# Flood Control Project Maintenance Levee Inspections LMA District Cover Sheet

## Lower San Joaquin Levee District

**Flood Control Project Maintenance  
Levee Inspections  
Unit Cover Sheet**

Waterway			Bank	Unit Miles
Unit No. 01 San Joaquin River			Right	22.52
	Spring (March - May)	Summer (June - August)	(September - November) Fall	Winter (December - February)
Unit Maintenance Rating (Fall Only)				
Date of Inspection	5/4/2021 - 5/4/2021			
DWR Inspector	Corey Fujitani			
Accompanied By

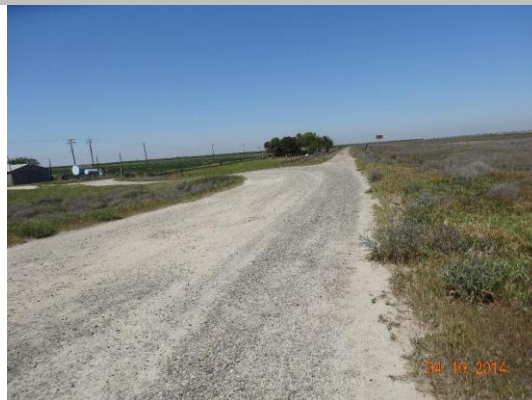
Photo 1 of 3 : UCIP\_SP\_2021\_39503\_66660.jpg

FS\_ID:39503  
DS\_ID:19925  
EP\_NO: 6603  
Repair Type: Non-Urgent  
Crossing Status: Found  
UCIP Comments: 04/10/2014 Need to contact owner. Appears abandoned--good candidate for video or pressure inspection. This crossings is the same age as the pipe that has failed immediately upstream. (DWR UCIP - O. Magana)  
FIELD\_STRUCT\_DESC: 15-inch steel irrigation discharge pipe through the levee, 4.3 feet below the crown. Electrical conduit of an unknown size or material through the levee, 4.3 feet below the crown. Siphon breaker on the landside (LS) shoulder. 36-inch concrete standpipe on the LS berm. Inlet facility on the waterside (WS) bank consisting of a pump, a 42-inch concrete standpipe, and a 20-inch concrete channel with an intake pipe and a cutoff wall. (Plans to install a pump and outlet pipe at two locations on the left bank levee of the Chowchilla Bypass authorized under Permit No. 6603, 1969 - Raymond N. Costales).

Overview of levee crown at crossing.

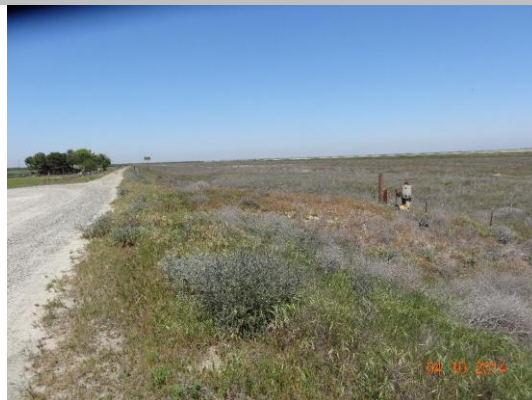
Photo 2 of 3 : UCIP\_SP\_2021\_39503\_66657.jpg

View of waterward side.

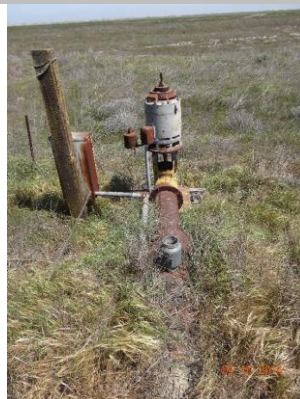
Photo 3 of 3 : UCIP\_SP\_2021\_39503\_66658.jpg

Pump system located on waterward slope.

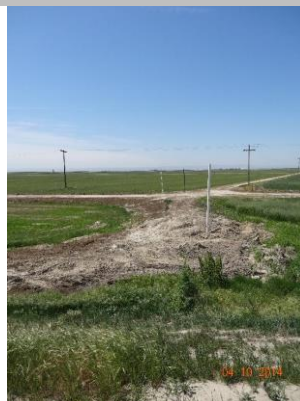
Photo 1 of 3 : UCIP\_SP\_2021\_49968\_60558.jpg

UCIP Comments: 7/20/2016 High burrow activity. Dense vegetation limits the inspector's visibility to identify signs of pipe failure (leaks) along the WS and LS slope. Recommend removing vegetation along pipe alignment to conduct proper inspection of structure and appurtenances. (DWR UCIP - omagana)4/10/2014 Subsidence present along pipe alignment on landward side. Modified crossing--worked done on landward side. Need to contact owner to determine permit authorizing work. Dense vegetation on landward side--tall grass. Pipe wall cut and new pipe sleeved on landward side. (DWR UCIP - omagana)

Overview of LS--site modified.

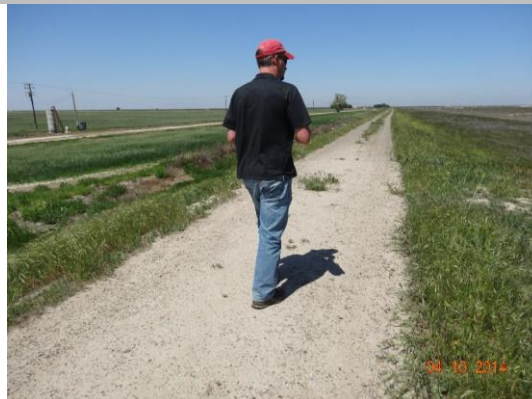
Photo 2 of 3 : UCIP\_SP\_2021\_49968\_60559.jpg

View of levee crown at crossing.

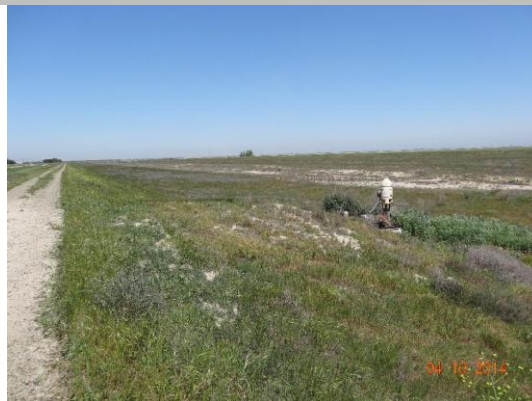
Photo 3 of 3 : UCIP\_SP\_2021\_49968\_60560.jpg

View of WS.

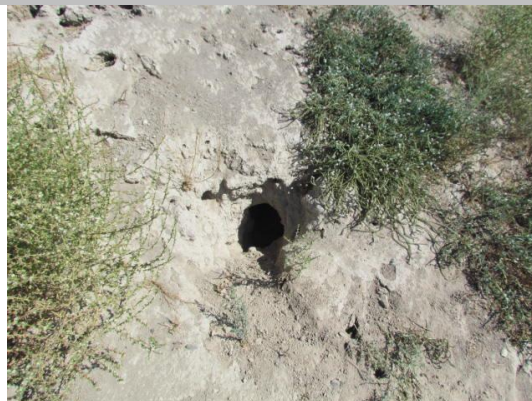
Photo 1 of 1 : SP\_2021\_NA0010\_137\_8\_20210308\_00004.jpg

LM Start	2.25	Rating **	U	Issue No.	8
LM End	2.25	Issue Type +	Ma	Location *	LS
Category	Earthen Levee			GPS Latitude/Longitude	
				Start	End
Item	Animal Control			36.945563 °	36.945563 °
				-120.347121 °	-120.347121 °
DWR ID	DWR_NA0010_18_f_2015_8				
Comment Code					
A3 : No rodents visible, but rodent burrows visible; need to backfill and compact or grout burrows.					
Inspector Comment					
There is one large rodent hole and other smaller rodent holes within this area.

Looking at large rodent hole on landward slope.

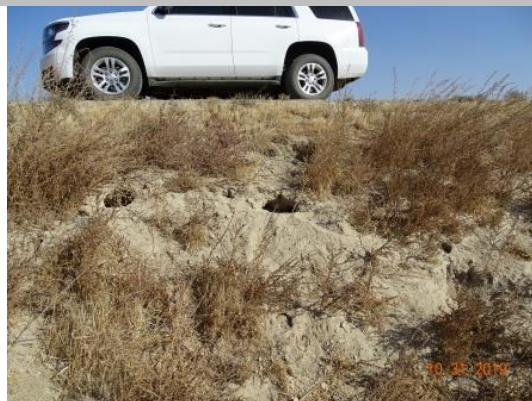
Photo 1 of 1 : SP\_2021\_NA0010\_137\_31\_20210308\_00014.jpg

LM Start	3.41	Rating **	U	Issue No.	31
LM End	3.44	Issue Type +	Ma	Location *	LS
Category	Earthen Levee			GPS Latitude/Longitude	
				Start	End
Item	Animal Control			36.929498 °	36.929093 °
				-120.341091 °	-120.340920 °
DWR ID	DWR_NA0010_18_f_2019_31				
Comment Code					
A3 : No rodents visible, but rodent burrows visible; need to backfill and compact or grout burrows.					
Inspector Comment

View of rodent burrows in the landside slope. (Fall 2019)

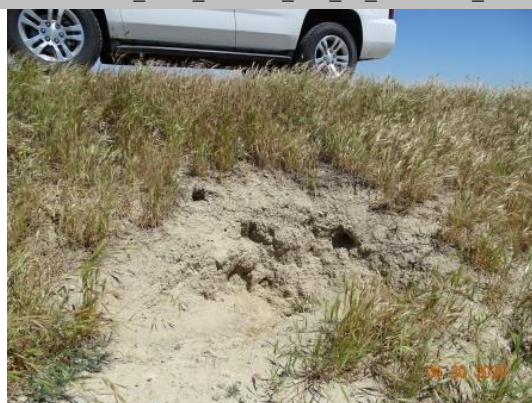
Photo 1 of 1 : SP\_2021\_NA0010\_137\_47\_20210308\_00015.jpg

LM Start	3.73	Rating **	U	Issue No.	47
LM End	3.73	Issue Type +	Ma	Location *	LS
Category	Earthen Levee			GPS Latitude/Longitude	
				Start	End
Item	Animal Control			36.924969 °	36.924969 °
				-120.339407 °	-120.339407 °
DWR ID	DWR_NA0010_18_s_2020_47				
Comment Code					
A3 : No rodents visible, but rodent burrows visible; need to backfill and compact or grout burrows.					
Inspector Comment

Large rodent burrow in the landside slope. (Spring 2020)

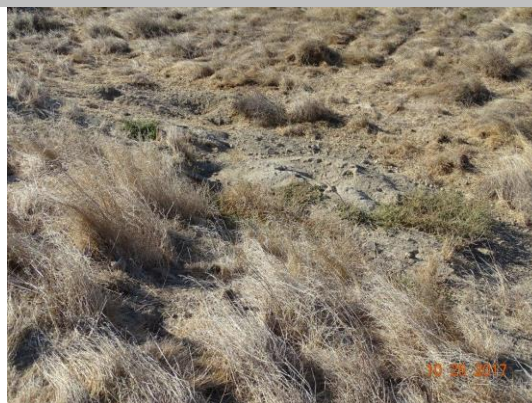
Photo 1 of 1 : SP\_2021\_NA0010\_137\_15\_20210308\_00008.jpg

LM Start	5.74	Rating **	U	Issue No.	15
LM End	5.99	Issue Type +	Ma	Location *	LS
Category	Earthen Levee			GPS Latitude/Longitude	
				Start	End
Item	Animal Control			36.897237 °	36.893924 °
				-120.328633 °	-120.327020 °
DWR ID	DWR_NA0010_18_f _ 2017_15				
Comment Code					
A3 : No rodents visible, but rodent burrows visible; need to backfill and compact or grout burrows.					
Inspector Comment					
There are multiple large rodent holes at the landside toe.

Looking west at the landside slope. (Fall 2017)

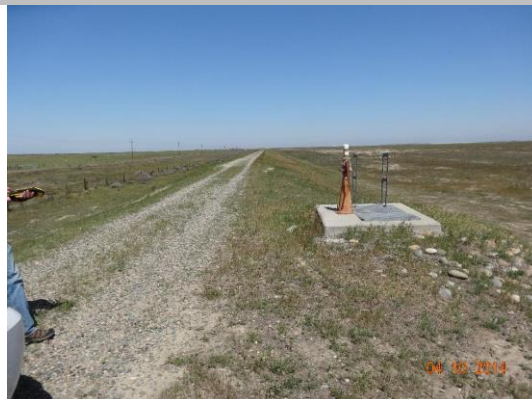
Photo 1 of 3 : UCIP\_SP\_2021\_36843\_67202.jpg

Comment Code						
Inspector Comment						
FS_ID:36843 DS_ID:19930 EP_NO: N/A Repair Type: Non-Urgent Crossing Status: Found UCIP Comments: 04/10/2014 CMP crossing is distorted on waterward side. Debris scattered on landward side. Sediment deposit inside crossing visible from landward side. Recommend removing debris from landward side. (DWR UCIP - O. Magana) FIELD_STRUCT_DESC: 42-inch reinforced concrete gravity irrigation pipe through the levee, 19 feet below the crown. Gate structure on the waterside (WS) shoulder. Pipe section on the WS is corrugated metal. Pipe section on the landside (LS) is reinforced concrete. (Plans to install a 42-inch gravity-flow concrete pipeline through the left bank levee of the Eastside Bypass to divert bypass waters for irrigation purposes authorized under Permit No. 13548, 1983 - New Stone Water District). [Additional Reference(s): DWR Levee Log, 2002]. FS Date: 4/10/2014

Overview of levee crown at crossing--slide gate inside concrete box located on waterward shoulder.

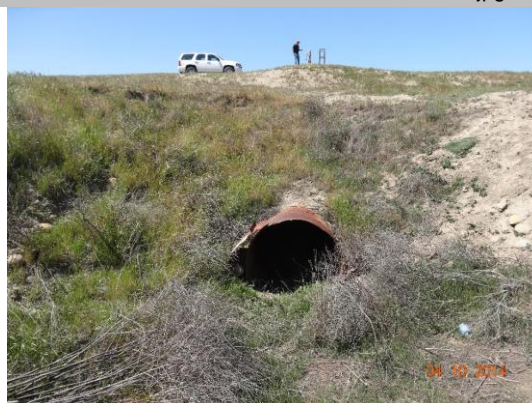
Photo 2 of 3 : UCIP\_SP\_2021\_36843\_67205.jpg

Pipe section distorted on waterward side.

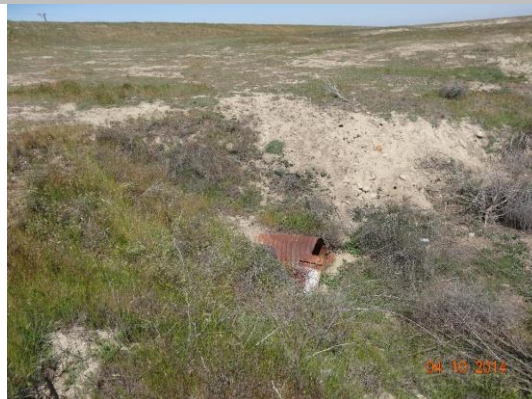
Photo 3 of 3 : UCIP\_SP\_2021\_36843\_67200.jpg

CMP section visible on waterward side.

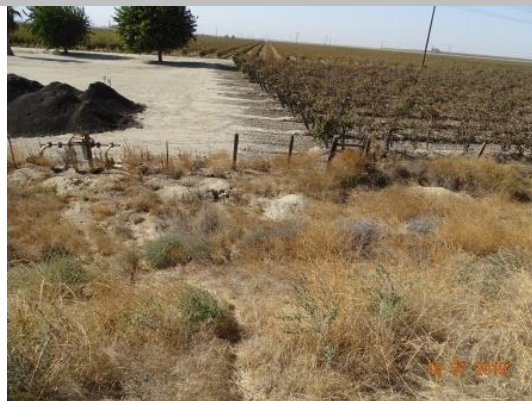
Photo 1 of 1 : SP\_2021\_NA0010\_137\_21\_20210308\_00011.jpg

LM Start	7.91	Rating **	U	Issue No.	21
LM End	7.91	Issue Type +	Ma	Location *	LS
Category	Earthen Levee			GPS Latitude/Longitude	
				Start	End
Item	Animal Control			36.867030 °	36.867030 °
				-120.318361 °	-120.318361 °
DWR ID	DWR_NA0010_18_f _ 2019_21				
Comment Code					
A3 : No rodents visible, but rodent burrows visible; need to backfill and compact or grout burrows.					
Inspector Comment					
Several large rodent burrows in the landside toe.

Several rodent burrows observed at the landside toe. (Fall 2019)

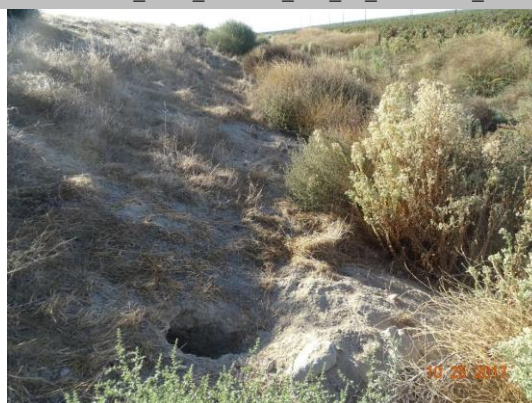
Photo 1 of 1 : SP\_2021\_NA0010\_137\_13\_20210308\_00006.jpg

LM Start	8.67	Rating **	U	Issue No.	13
LM End	8.67	Issue Type +	Ma	Location *	LS
Category	Earthen Levee			GPS Latitude/Longitude	
				Start	End
Item	Animal Control			36.856115 °	36.856115 °
				-120.316595 °	-120.316595 °
DWR ID	DWR_NA0010_18_f_2017_13				
Comment Code					
A3 : No rodents visible, but rodent burrows visible; need to backfill and compact or grout burrows.					
Inspector Comment

Looking south at the landside slope.

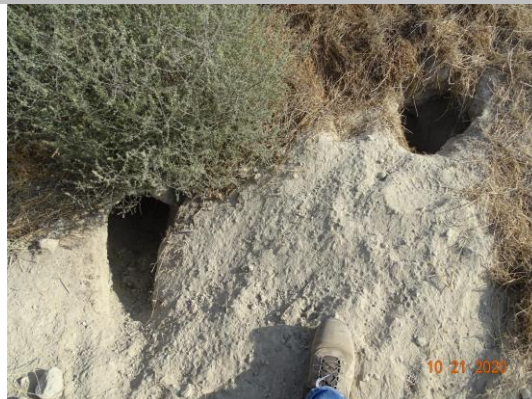
Photo 1 of 1 : SP\_2021\_NA0010\_137\_18\_20210308\_00010.jpg

LM Start	8.89	Rating **	U	Issue No.	18
LM End	8.89	Issue Type +	Ma	Location *	LS
Category	Earthen Levee			GPS Latitude/Longitude	
				Start	End
Item	Animal Control			36.852936 °	36.852936 °
				-120.316451 °	-120.316451 °
DWR ID	DWR_NA0010_18_f_2020_18				
Comment Code					
A3 : No rodents visible, but rodent burrows visible; need to backfill and compact or grout burrows.					
Inspector Comment

Large rodent holes in the landside slope. (Fall 2020)

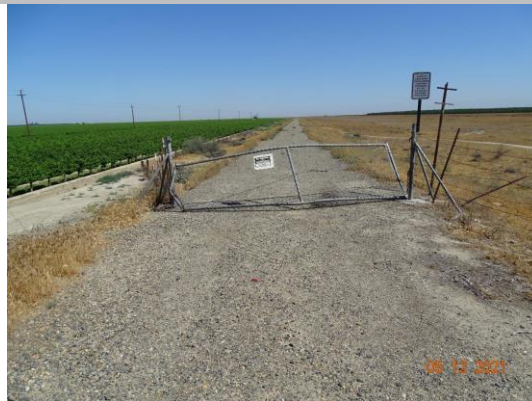
Photo 1 of 1 : SP\_2021\_NA0010\_137\_17\_20210520\_00031.jpg

LM Start	8.99	Rating **	U	Issue No.	17
LM End	8.99	Issue Type +	Ma	Location *	CR
Category	Earthen Levee			GPS Latitude/Longitude	
				Start	End
Item	Repair Gates			36.851459 °	36.851459 °
				-120.316387 °	-120.316387 °
DWR ID	DWR_NA0010_18_f _ 2020_17				
Comment Code					
Inspector Comment					
Gate has broken off the hinges and is no longer operable.

View of damaged access gate across the levee crown. (Spring 2021)

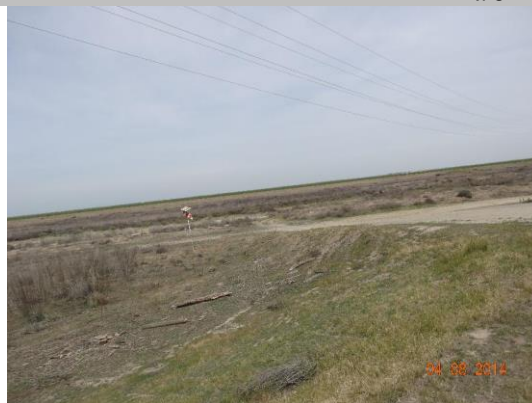
Photo 1 of 3 : UCIP\_SP\_2021\_39505\_67226.jpg

LM Start	13.59	Rating **	M	Issue No.	4
LM End	13.59	Issue Type +	En	Location *	
Category	Supplemental			GPS Latitude/Longitude	
				Start	End
Item	DWR UCIP Field Study			36.792684 °	36.792684 °
				-120.304542 °	-120.304542 °
DWR ID	19932				
Comment Code					
Inspector Comment					
FS_ID:39505 DS_ID:19932 EP_NO: N/A Repair Type: Non-Urgent Crossing Status: Indicator Found UCIP Comments: 04/08/2014 Multiple markers visible along waterward and landward sides unable to confirm how many crossings go through levee. Need to contact owner to obtain additional details on crossings. (DWR UCIP - O. Magana) FIELD_STRUCT_DESC: 6-inch natural gas pipeline of an unknown material through the levee. Pipeline extends underneath the channel. [Additional Reference(s): DWR Levee Log, 2002]. FS Date: 4/8/2014

Markers visible on waterward side.

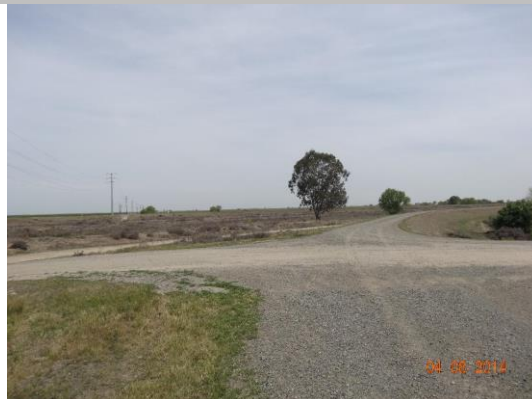
Photo 2 of 3 : UCIP\_SP\_2021\_39505\_67225.jpg

View of levee crown at crossing.

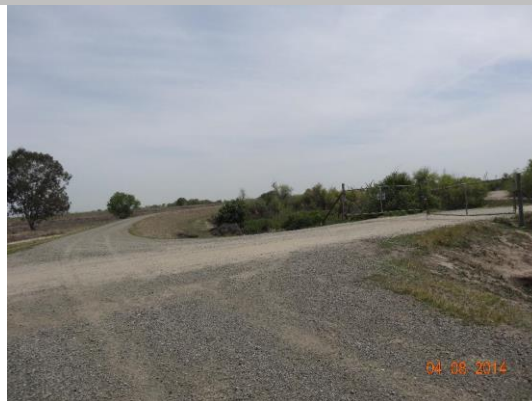
Photo 3 of 3 : UCIP\_SP\_2021\_39505\_67224.jpg

Ramp visible on landward side.

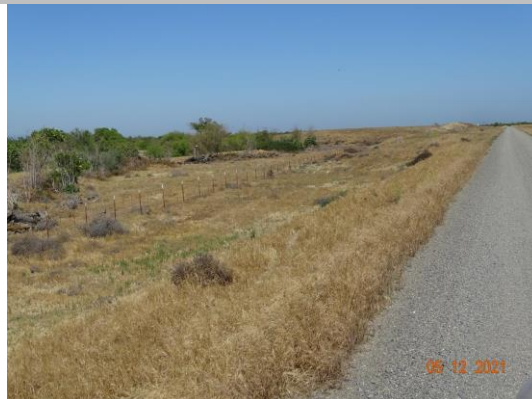
Photo 1 of 1 : SP\_2021\_NA0010\_137\_6\_20210520\_00032.jpg

LM Start	14.76	Rating **	M	Issue No.	6
LM End	14.97	Issue Type +	Ma	Location *	LS
Category	Earthen Levee			GPS Latitude/Longitude	
				Start	End
Item	Vegetation			36.779886 °	36.778088 °
				-120.291918 °	-120.288920 °
DWR ID	DWR_NA0010_18_s_2021_6				
Comment Code					
V1 : Control annual grass and weeds on the levee slopes and easements.					
Inspector Comment

View of vegetation on the landside slope. (Spring 2021)

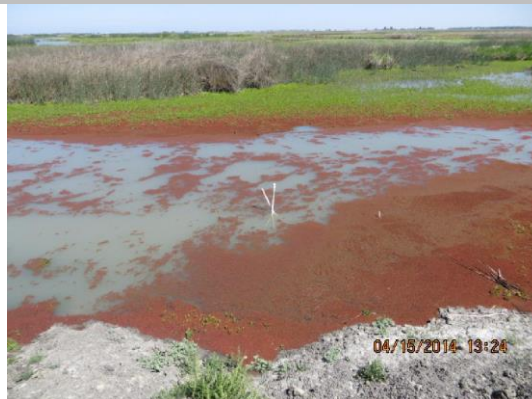
Photo 1 of 3 : UCIP\_SP\_2021\_62171\_61060.jpg

FS\_ID:62171  
DS\_ID:19933  
EP\_NO: N/A  
Repair Type: Non-Urgent  
Crossing Status: Found  
UCIP Comments: 07/19/2016 Gate inside riser appears operable--riser lid damage. Crossing is not visible on LS due to dense vegetation. Recommend clearing dense vegetation along WS and LS slope and repairing riser cover. (O. Magana - DWR UCIP)04/15/2014 No actuator wheel on slide gate at WS shoulder. (W. Wylie - DWR UCIP) FIELD\_STRUCT\_DESC: 24-inch corrugated metal gravity drainage pipe through the levee, 14.8 feet below the crown. Slide gate in a 36-inch corrugated metal pipe (CMP) riser on the waterside (WS) slope. Concrete U-shaped headwall on each end. [Additional Reference(s): DWR Levee Log, 2002 (HLM 0.10), listed as a 24-inch corrugated metal pipe (CMP). USACE San Joaquin O&M Manual, Unit 601 Part 1 (SJR601.1), 1967, Revised 25 May 2011, (HLM 0.10), listed as a 24-inch CMP].  
FS Date: 7/19/2016

PVC pipes sticking up out of channel likely indicate pipe location on WS toe.

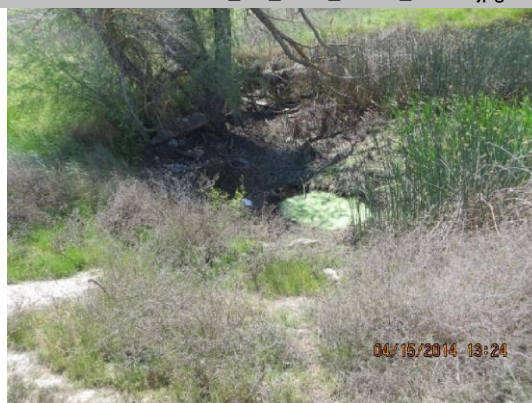
Photo 2 of 3 : UCIP\_SP\_2021\_62171\_61061.jpg

Concrete headwall at toe of LS slope.

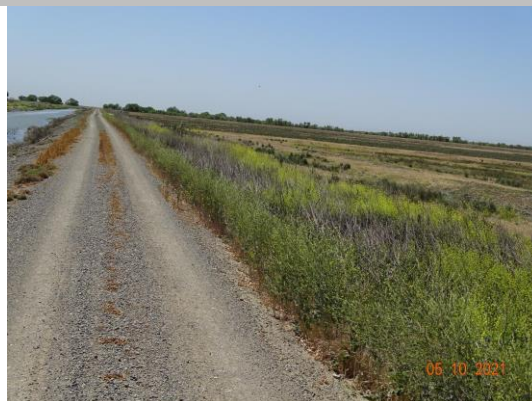
Photo 1 of 1 : SP\_2021\_NA0010\_138\_21\_20210520\_00045.jpg

LM Start	0.45	Rating **	U	Issue No.	21
LM End	1.42	Issue Type +	Ma	Location *	LS
Category	Earthen Levee			GPS Latitude/Longitude	
				Start	End
Item	Vegetation			37.211802 °	37.225553 °
				-120.697901 °	-120.700209 °
DWR ID	DWR_NA0010_22A_s_2021_21				
Comment Code					
V1 : Control annual grass and weeds on the levee slopes and easements.					
Inspector Comment

Dense vegetation growing on the landside slope. (Spring 2021)

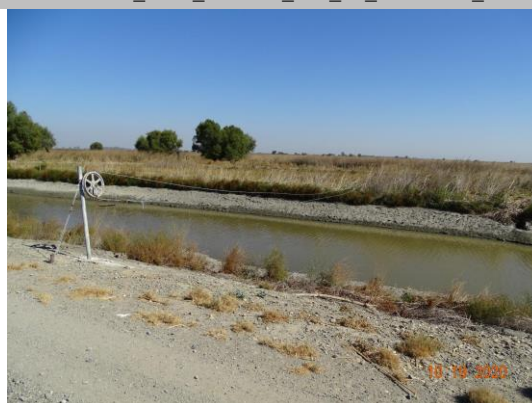
Photo 1 of 1 : SP\_2021\_NA0010\_138\_23\_20210308\_00027.jpg

LM Start	0.87	Rating **	M	Issue No.	23
LM End	0.87	Issue Type +	En	Location *	WS
Category	Earthen Levee			GPS Latitude/Longitude	
				Start	End
Item	Encroachments			37.217802 °	37.217802 °
				-120.697416 °	-120.697416 °
DWR ID	DWR_NA0010_22A_f_2014_23				
Comment Code					
SI : Sign					
Inspector Comment					
A pulley is located on the waterside shoulder without a board permit.

Pulley on the waterside shoulder. (Fall 2020)

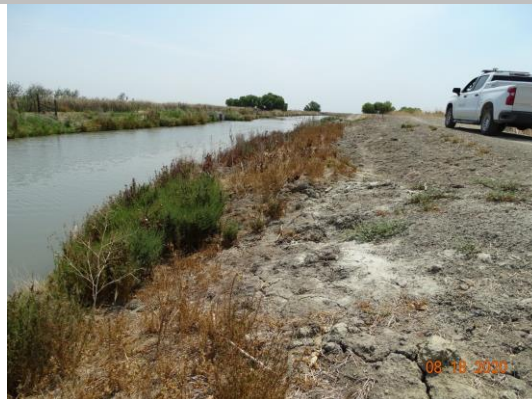
Photo 1 of 2 : SP\_2021\_NA0010\_138\_1\_20210308\_00001.jpg

LM Start	1.04	Rating **	M	Issue No.	1
LM End	1.04	Issue Type +	Ma	Location *	WS
Category	Supplemental			GPS Latitude/Longitude	
				Start	End
Item	DWR Erosion Survey			37.220281 °	37.220281 °
				-120.698287 °	-120.698287 °
DWR ID	NA0010U22RM5.47				
Comment Code					
Inspector Comment					
Site ID: NA0010U22RM5.47 08/18/2020: No changes observed since the previous inspection. 08/28/2019: Two erosion pockets were found at the site, close to levee shoulder, and likely caused by animal activities.

8/18/2020: View of the levee slope looking upstream.

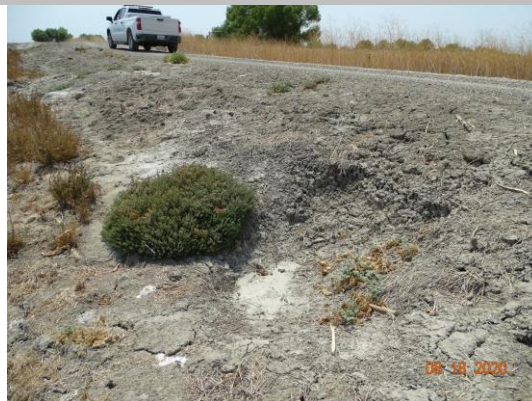
Photo 2 of 2 : SP\_2021\_NA0010\_138\_1\_20210308\_00002.jpg

8/18/2020: Close-up view of one of the two erosion pockets.

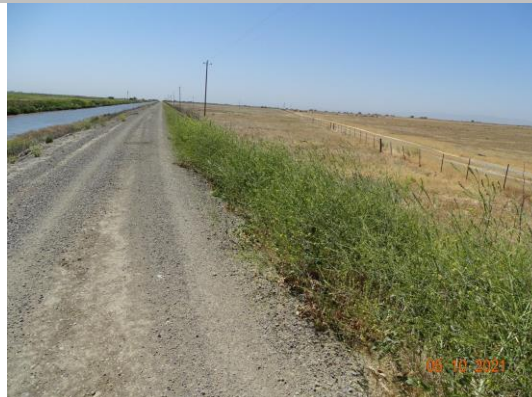
Photo 1 of 1 : SP\_2021\_NA0010\_138\_5\_20210520\_00046.jpg

LM Start	1.43	Rating **	M	Issue No.	5
LM End	2.62	Issue Type +	Ma	Location *	LS
Category	Earthen Levee			GPS Latitude/Longitude	
				Start	End
Item	Vegetation			37.225624 °	37.242154 °
				-120.700234 °	-120.706277 °
DWR ID	DWR_NA0010_22A_s_2021_5				
Comment Code					
V1 : Control annual grass and weeds on the levee slopes and easements.					
Inspector Comment

View of vegetation growing on the landside slope. (Spring 2021)

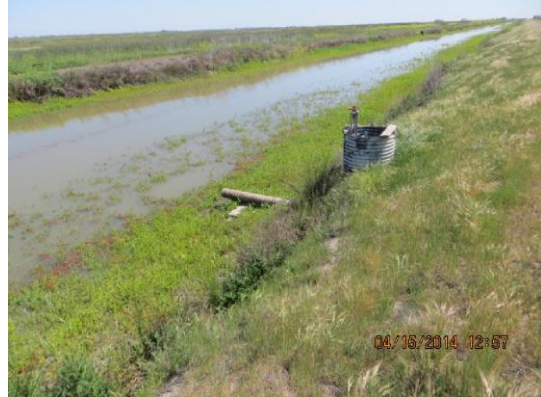
Photo 1 of 3 : UCIP\_SP\_2021\_62180\_61030.jpg

Comment Code						
Inspector Comment						
FS_ID:62180						
DS_ID:19936						
EP_NO: N/A						
Repair Type: Non-Urgent						
Crossing Status: Found						
UCIP Comments: 04/15/2014 Slide gate rusted and does not function.						
Headwall buried at LS toe. Pipe appears abandoned and if so should						
be done so properly. (W. Wylie - DWR UCIP)						
FIELD_STRUCT_DESC: 8-inch corrugated metal gravity irrigation pipe						
through the levee, 7 feet below the crown. Slide gate in a 36-inch						
corrugated metal pipe (CMP) riser on the waterside (WS) slope.						
Concrete headwall on the landside (LS) end. [Additional Reference(s):						
DWR Levee Log, 2002 (HLM 1.57), listed as a 8-inch corrugated metal						
pipe (CMP). USACE San Joaquin O&M Manual, Unit 601 Part 1						
(SJR601.1), 1967, Revised 25 May 2011, (HLM 1.57), listed as a 8-inch						
CMP]						
FS Date: 4/15/2014

Pipe and CMP riser with slide gate visible on WS slope.

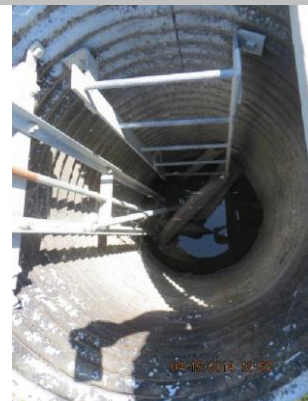
Photo 2 of 3 : UCIP\_SP\_2021\_62180\_61029.jpg

Inside CMP riser on WS shoulder.

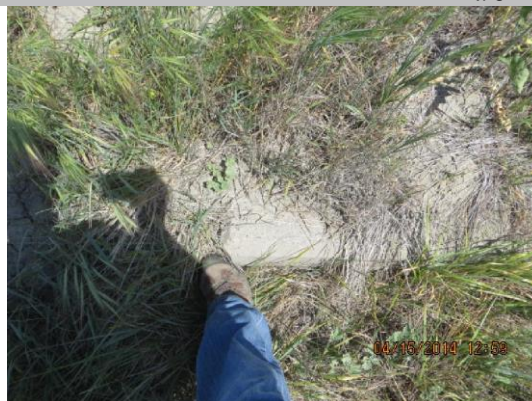
Photo 3 of 3 : UCIP\_SP\_2021\_62180\_61028.jpg

Burried concrete headwall on LS toe.

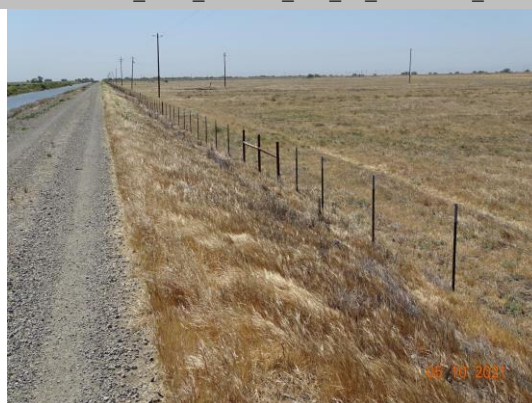
Photo 1 of 1 : SP\_2021\_NA0010\_138\_28\_20210520\_00047.jpg

LM Start	1.75	Rating **	M	Issue No.	28
LM End	2.60	Issue Type +	En	Location *	LS
Category	Earthen Levee			GPS Latitude/Longitude	
				Start	End
Item	Encroachments			37.230585 °	37.242371 °
				-120.702045 °	-120.706371 °
DWR ID	DWR_NA0010_22A_f_2018_28				
Comment Code					
FE : Fence					
Inspector Comment					
A fence is located along the landside toe.

View of fence along landside toe. (Spring 2021)

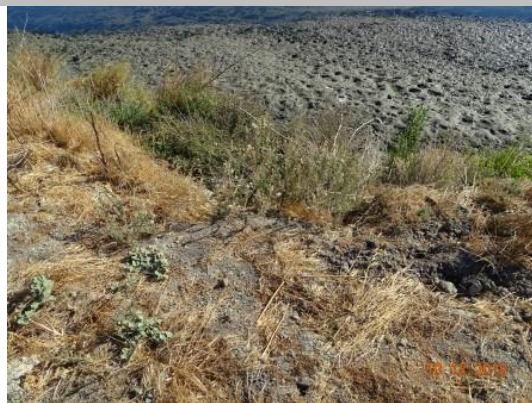
Photo 1 of 1 : SP\_2021\_NA0010\_138\_29\_20210308\_00029.jpg

LM Start	2.20	Rating **	M	Issue No.	29
LM End	2.37	Issue Type +	Ma	Location *	WS
Category	Earthen Levee			GPS Latitude/Longitude	
				Start	End
Item	Animal Control			37.236392 °	37.238776 °
				-120.704165 °	-120.705028 °
DWR ID	DWR_NA0010_22A_f_2018_29				
Comment Code					
A2 : Repair the levee slope damaged by livestock and prevent large animal access.					
Inspector Comment					
There is slope erosion from livestock, the slope is no longer 3:1.

View of waterside slope from levee crown. (Fall 2018)

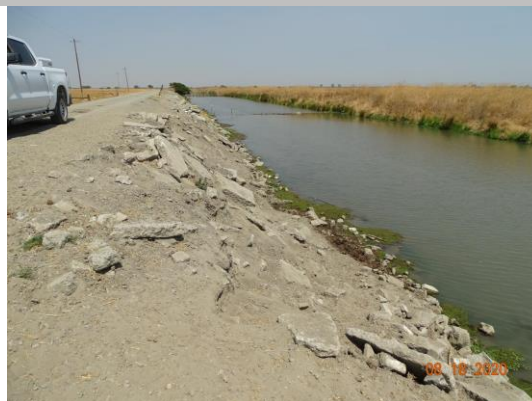
Photo 1 of 2 : SP\_2021\_NA0010\_138\_2\_20210308\_00003.jpg

LM Start	2.65	Rating **	U	Issue No.	2
LM End	2.66	Issue Type +	Ma	Location *	WS
Category	Supplemental			GPS Latitude/Longitude	
				Start	End
Item	DWR Erosion Survey			37.242595 °	37.242595 °
				-120.706470 °	-120.706470 °
DWR ID	NA0010U22RM3.87				
Comment Code					
Inspector Comment					
Site ID: NA0010U22RM3.87					
08/18/2020: The site has been covered with loose fill and crushed concrete pieces. The erosion will likely worsen again during the next high water.					
09/12/2019: The erosion has cut into the levee prism and damaged almost half of the levee. The livestock traffic has likely caused the erosion.

8/18/2020: View of the erosion looking downstream with fill and crushed concrete.

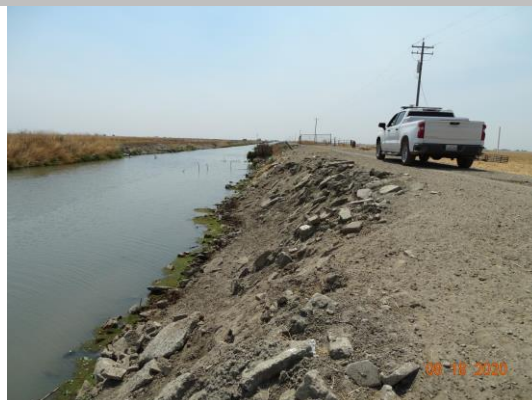
Photo 2 of 2 : SP\_2021\_NA0010\_138\_2\_20210308\_00004.jpg

8/18/2020: View of the erosion looking upstream.

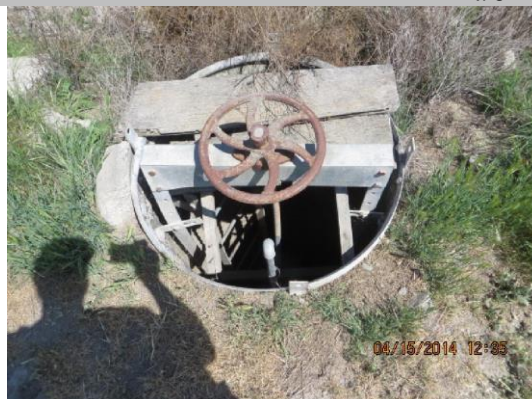
Photo 1 of 3 : UCIP\_SP\_2021\_62181\_61026.jpg

Comment Code					
Inspector Comment					
FS_ID:62181					
DS_ID:19937					
EP_NO: N/A					
Repair Type: Non-Urgent					
Crossing Status: Found					
UCIP Comments: 04/15/2014 Slide gate does not function and should be repaired. Headwall at LS toe not found. (W. Wylie - DWR UCIP)					
FIELD_STRUCT_DESC: 24-inch corrugated metal irrigation siphon pipe through the levee, 7.5 feet below the crown. Slide gate in a 36-inch corrugated metal pipe (CMP) riser on the waterside (WS) slope.					
Concrete U-shaped headwall on the landside (LS) end. [Additional Reference(s): DWR Levee Log, 2002 (HLM 2.72), listed as a 24-inch corrugated metal pipe (CMP). USACE San Joaquin O&M Manual, Unit 601 Part 1 (SJR601.1), 1967, Revised 25 May 2011, (HLM 2.72), listed as a 24-inch CMP].					
FS Date: 4/15/2014

Slidegate in CMP riser on WS shoulder. (Note: actuator does not work).

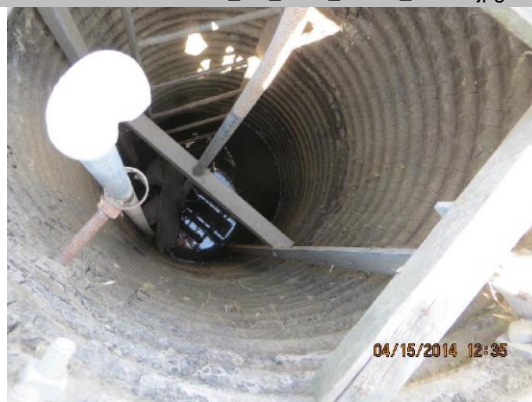
Photo 2 of 3 : UCIP\_SP\_2021\_62181\_61024.jpg

Inside CMP riser on WS shoulder.

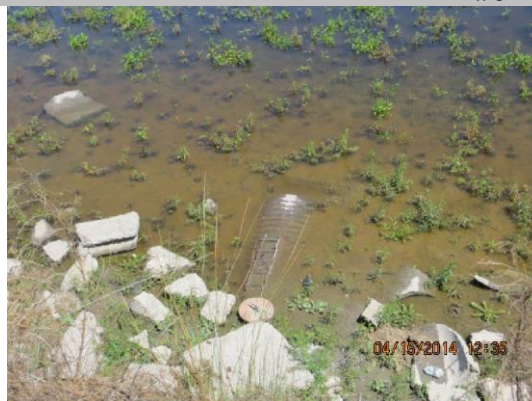
Photo 3 of 3 : UCIP\_SP\_2021\_62181\_61025.jpg

Pipe visible on WS toe.

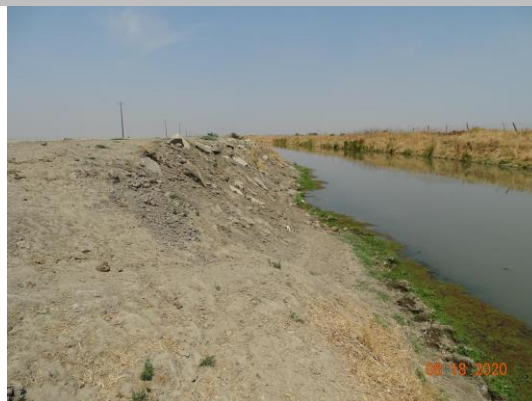
Photo 1 of 3 : SP\_2021\_NA0010\_138\_4\_20210308\_00008.jpg

08/18/2020: No changes observed since the previous inspection. In some areas, the levee shoulder width is up to 8 ft. There is some crushed concrete on the levee slope.

09/12/2019: The erosion has damaged entire levee slope. The livestock traffic likely has caused the erosion.

8/18/2020: View of the erosion looking downstream.

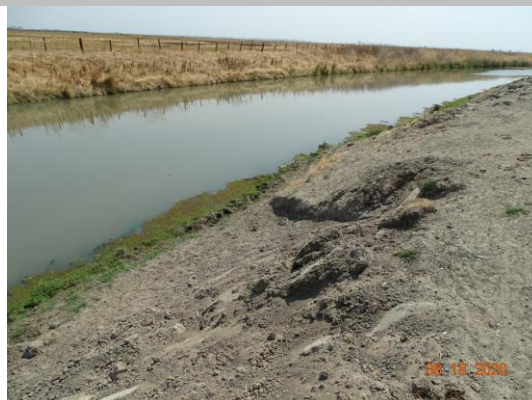
Photo 2 of 3 : SP\_2021\_NA0010\_138\_4\_20210308\_00009.jpg

8/18/2020: Close-up view of the erosion.

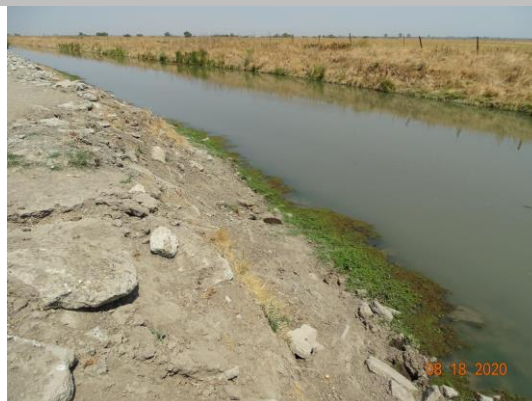
Photo 3 of 3 : SP\_2021\_NA0010\_138\_4\_20210308\_00010.jpg

8/18/2020: View of the erosion looking downstream with crushed concrete visible on the levee slope.

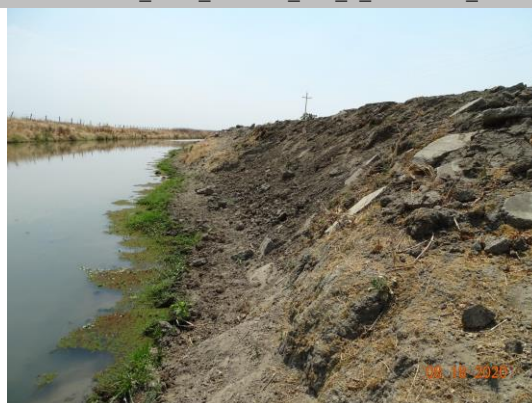
Photo 1 of 3 : SP\_2021\_NA0010\_138\_7\_20210308\_00013.jpg

08/18/2020: No vegetation visible in the area of the erosion. Noticed some crushed concrete pieces on the levee slope and a small amount of loose fill.

09/12/2019: The erosion has damaged entire levee slope. The livestock traffic likely has caused the erosion.

8/18/2020: View of the erosion looking upstream.

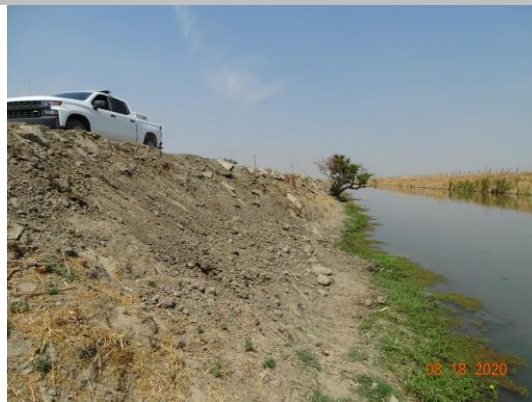
Photo 2 of 3 : SP\_2021\_NA0010\_138\_7\_20210308\_00014.jpg

8/18/2020: View of the erosion looking downstream.

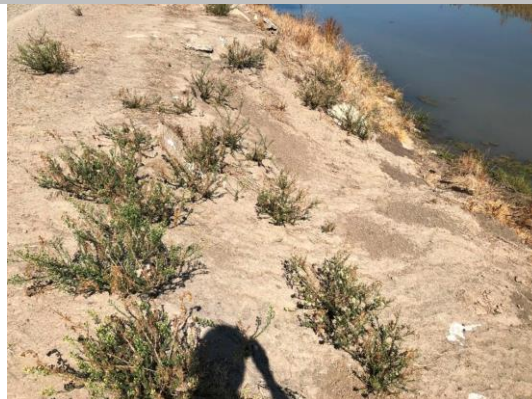
Photo 3 of 3 : SP\_2021\_NA0010\_138\_7\_20210308\_00015.jpg

9/12/2020: Close-up view of the erosion.

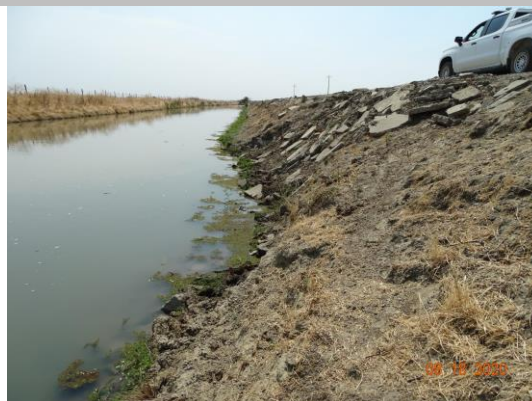
Photo 1 of 3 : SP\_2021\_NA0010\_138\_10\_20210308\_00018.jpg

08/18/2020: The erosion has been covered with loose fill and crushed concrete pieces. A nearly vertical slope remains at the levee toe in some sections. The site will likely worsen again during the next high water.

09/12/2019: The erosion has damaged entire levee slope. The livestock activity likely has caused the erosion.

8/18/2020: View of the erosion and crushed concrete on the slope.

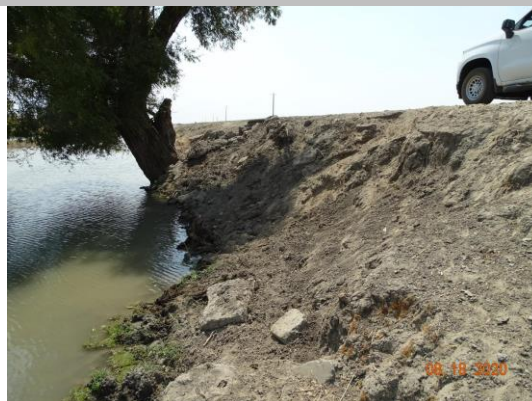
Photo 2 of 3 : SP\_2021\_NA0010\_138\_3\_20210308\_00006.jpg

8/18/2020: View of the erosion looking upstream.

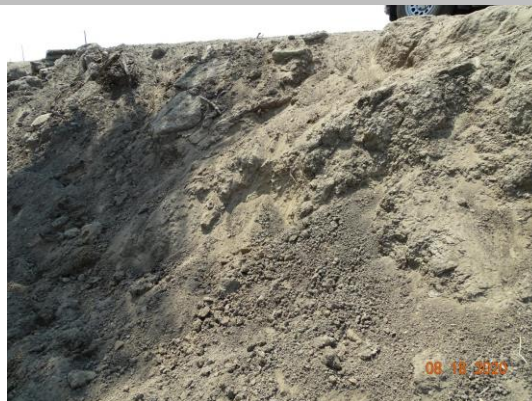
Photo 3 of 3 : SP\_2021\_NA0010\_138\_3\_20210308\_00007.jpg

8/18/2020: Close-up view of the erosion.

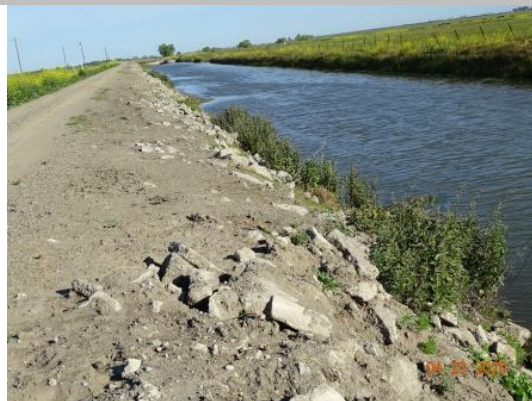
Photo 1 of 1 : SP\_2021\_NA0010\_138\_34\_20210308\_00030.jpg

Fill and concrete were placed to repair erosion on the waterside slope. Concrete with rebar should be removed. (Spring 2020)

LM Start	3.44	Rating **	U	Issue No.	34
LM End	3.44	Issue Type +	Ma	Location *	WS
Category	Earthen Levee			GPS Latitude/Longitude	
				Start	End
Item	Animal Control			37.251370 °	37.251370 °
				-120.715344 °	-120.715344 °
DWR ID	DWR_NA0010_22A_f_2018_34				
Comment Code					
A2 : Repair the levee slope damaged by livestock and prevent large animal access.					
Inspector Comment					
Broken concrete was placed on the waterside slope to prevent erosion from livestock. Concrete with rebar should be removed.

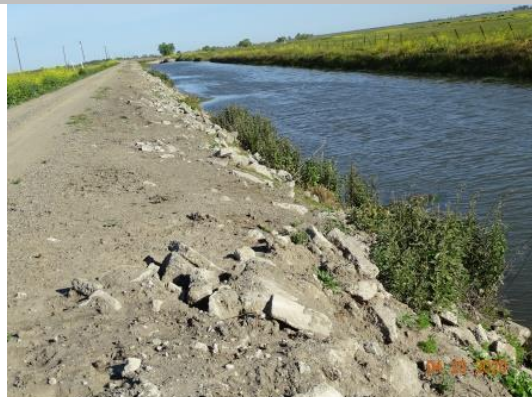
Photo 1 of 1 : SP\_2021\_NA0010\_138\_35\_20210308\_00031.jpg

Fill and concrete placed on the waterside slope. Rebar should be removed for safety. (Spring 2020)

LM Start	3.47	Rating **	U	Issue No.	35
LM End	3.47	Issue Type +	Ma	Location *	WS
Category	Earthen Levee			GPS Latitude/Longitude	
				Start	End
Item	Animal Control			37.251621 °	37.251621 °
				-120.715649 °	-120.715649 °
DWR ID	DWR_NA0010_22A_f_2018_35				
Comment Code					
A2 : Repair the levee slope damaged by livestock and prevent large animal access.					
Inspector Comment					
Waterside slope erosion is from livestock activity. Slope stabilized with borken concrete. Concrete with rebar in it should be removed.

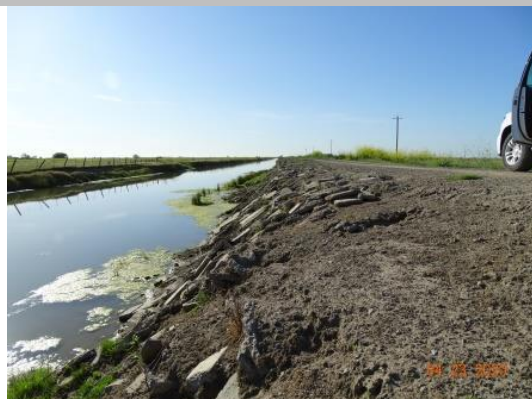
Photo 1 of 1 : SP\_2021\_NA0010\_138\_9\_20210308\_00017.jpg

View of waterside slope looking upstream. (Spring 2020)

LM Start	3.64	Rating **	U	Issue No.	9
LM End	3.69	Issue Type +	Ma	Location *	WS
Category	Earthen Levee			GPS Latitude/Longitude	
				Start	End
Item	Animal Control			37.253362 °	37.253862 °
				-120.717873 °	-120.718507 °
DWR ID	DWR_NA0010_22A_f_2016_9				
Comment Code					
A2 : Repair the levee slope damaged by livestock and prevent large animal access.					
Inspector Comment					
Broken concrete has been placed to limit further erosion caused by livestock. Concrete with rebar should be removed.

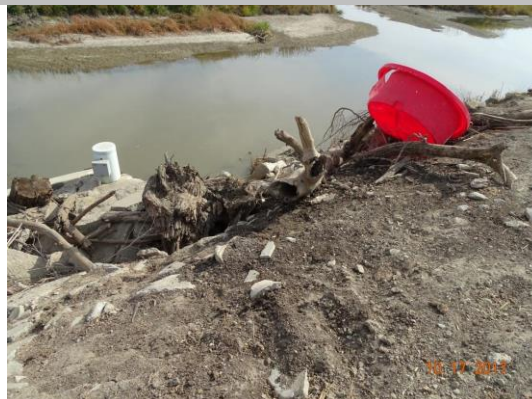
Photo 1 of 1 : SP\_2021\_NA0010\_138\_13\_20210308\_00024.jpg

Looking northeast at the waterside slope.

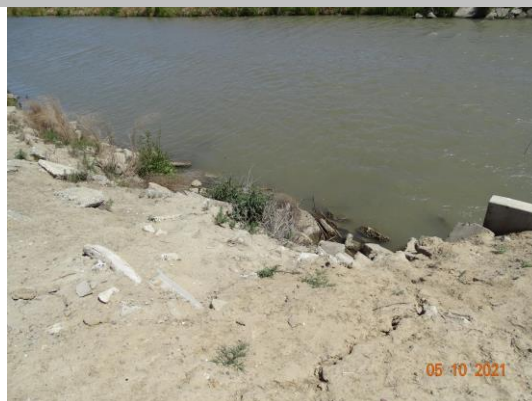
Photo 1 of 1 : SP\_2021\_NA0010\_138\_14\_20210520\_00048.jpg

LM Start	3.82	Rating **	M	Issue No.	14
LM End	3.82	Issue Type +	Ma	Location *	WS
Category	Earthen Levee			GPS Latitude/Longitude	
				Start	End
Item	Slope Stability			37.255239 °	37.255239 °
				-120.720142 °	-120.720142 °
DWR ID	DWR_NA0010_22A_f_2017_14				
Comment Code					
S1 : Repair slope instability.					
Inspector Comment					
Broken concrete previously placed to stabilize the slope has washed out.

Damage to the waterside slope. (Spring 2021)

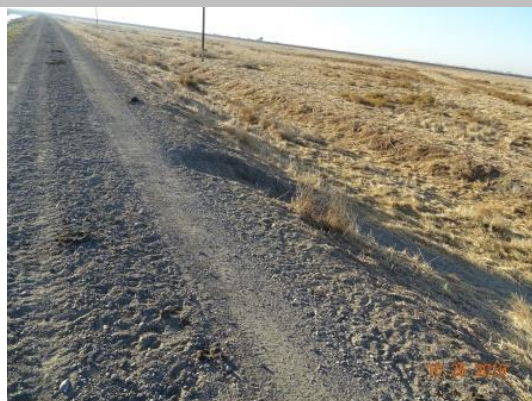
Photo 1 of 1 : SP\_2021\_NA0010\_138\_15\_20210308\_00026.jpg

View of erosion in the landside slope and shoulder from livestock traffic.  
(Fall 2019)

LM Start	4.11	Rating **	M	Issue No.	15
LM End	4.11	Issue Type +	Ma	Location *	LS
Category	Earthen Levee			GPS Latitude/Longitude	
				Start	End
Item	Animal Control			37.258353 °	37.258353 °
				-120.723824 °	-120.723824 °
DWR ID	DWR_NA0010_22A_f_2019_15				
Comment Code					
A2 : Repair the levee slope damaged by livestock and prevent large animal access.					
Inspector Comment

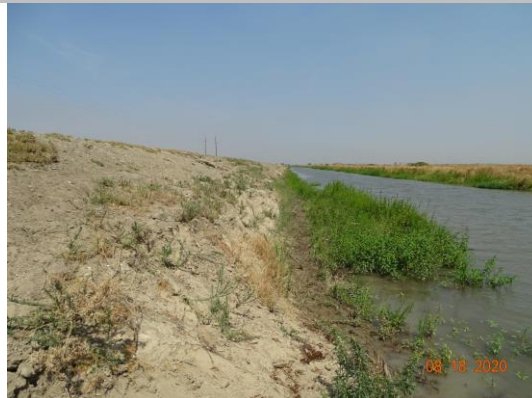
Photo 1 of 3 : SP\_2021\_NA0010\_138\_12\_20210308\_00021.jpg

818/2020: Close-up view of the erosion looking downstream.

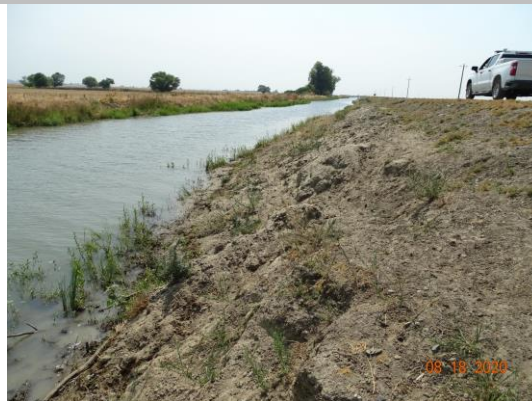
Photo 2 of 3 : SP\_2021\_NA0010\_138\_12\_20210308\_00022.jpg

818/2020: Close-up view of the erosion looking upstream.

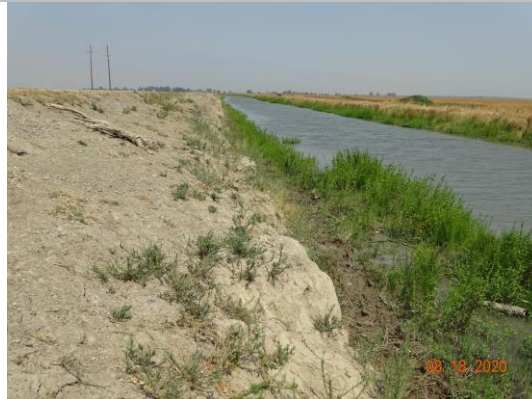
Photo 3 of 3 : SP\_2021\_NA0010\_138\_12\_20210308\_00023.jpg

818/2020: Another close-up view of the erosion looking downstream.

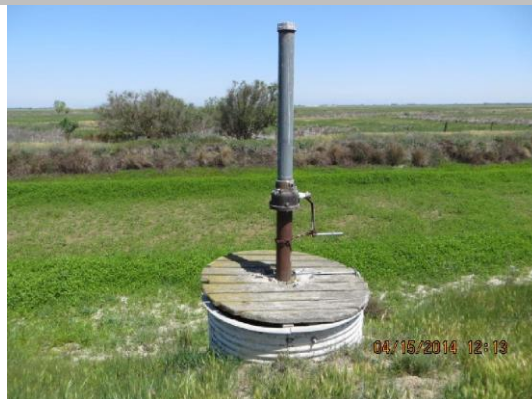
Photo 1 of 3 : UCIP\_SP\_2021\_62182\_61022.jpg

Comment Code						
Inspector Comment						
FS_ID:62182 DS_ID:19938 EP_NO: N/A Repair Type: Non-Urgent Crossing Status: Found UCIP Comments: 04/15/2014 Need to contact owner. Pipe silted in on LS toe. Appears abandoned and if so should be done so properly. (W. Wylie - DWR UCIP) FIELD_STRUCT_DESC: 48-inch corrugated metal irrigation siphon pipe through the levee, 10 feet below the crown. Slide gate in a 60-inch corrugated metal pipe (CMP) riser on the waterside (WS) slope. Concrete headwall on the landside (LS) end. WS end capped with a 0.25-inch steel plate. [Additional Reference(s): DWR Levee Log, 2002 (HLM 5.48), listed as a 48-inch corrugated metal pipe (CMP). USACE San Joaquin O&M Manual, Unit 601 Part 1 (SJR601.1), 1967, Revised 25 May 2011, (HLM 5.48), listed as a 48-inch CMP] FS Date: 4/15/2014

Slidegate inside riser on WS shoulder.

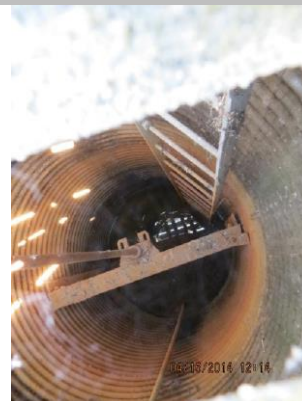
Photo 2 of 3 : UCIP\_SP\_2021\_62182\_61021.jpg

Inside riser on WS shoulder.

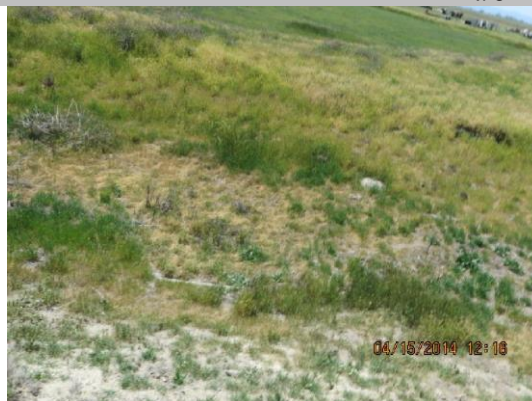
Photo 3 of 3 : UCIP\_SP\_2021\_62182\_61020.jpg

Burried headwall on LS toe.

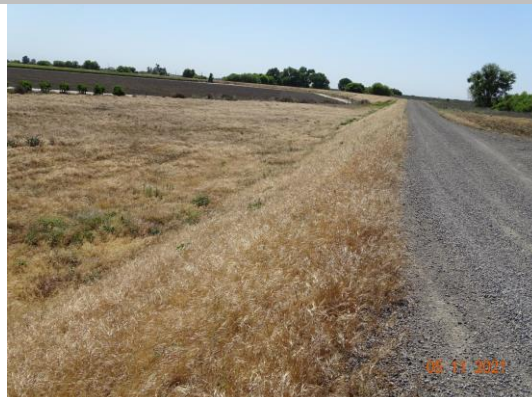
Photo 1 of 1 : SP\_2021\_NA0010\_139\_22\_20210520\_00040.jpg

View of the landside slope looking upstream. (Spring 2021)

LM Start	0.01	Rating **	M	Issue No.	22
LM End	4.33	Issue Type +	Ma	Location *	LS
Category	Earthen Levee			GPS Latitude/Longitude	
				Start	End
Item	Vegetation			36.774335 °	36.783882 °
				-120.283626 °	-120.225285 °
DWR ID	DWR_NA0010_23_s_2021_22				
Comment Code					
V1 : Control annual grass and weeds on the levee slopes and easements.					
Inspector Comment

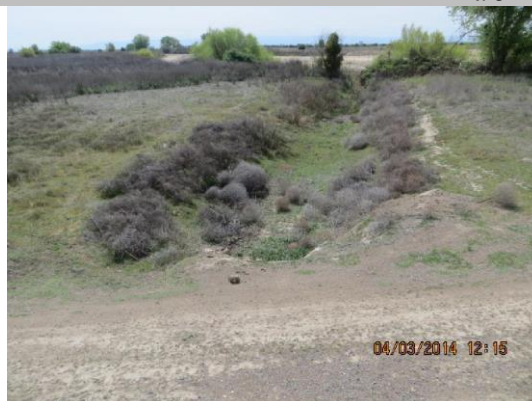
Photo 1 of 3 : UCIP\_SP\_2021\_62191\_59860.jpg

Comment Code						
Inspector Comment						
FS_ID:62191 DS_ID:19945 EP_NO: N/A Repair Type: Non-Urgent Crossing Status: Found UCIP Comments: 04/03/2014 Excessive vegetation at inlet--recommend clearing. (W. Wylie - DWR UCIP) FIELD_STRUCT_DESC: 30-inch by 30-inch square reinforced concrete box gravity drainage culvert through the levee, 13 feet below the crown. Flap gate on the waterside (WS) end. Concrete headwall on the landside (LS) end. Concrete U-shaped headwall on the WS end. (Plans to construct a new discharge structure and to rehabilitate one existing diversion structure to return intercepted seepage to the San Joaquin River authorized under Permit No. 13085, 1981 - Diener, Dry River Farms). [Additional Reference(s): DWR Levee Log, 2002 (HLM 0.21), listed as a 30-inch square reinforced concrete box culvert (RCBC). USACE San Joaquin O&M Manual, Unit 601 Part 1 (SJR601.1), 1967, Revised 25 May 2011, (HLM 0.21), listed as a 2.5-foot by 2.5-foot RCBC] FS Date: 4/3/2014

Concrete headwall on WS toe at channel.

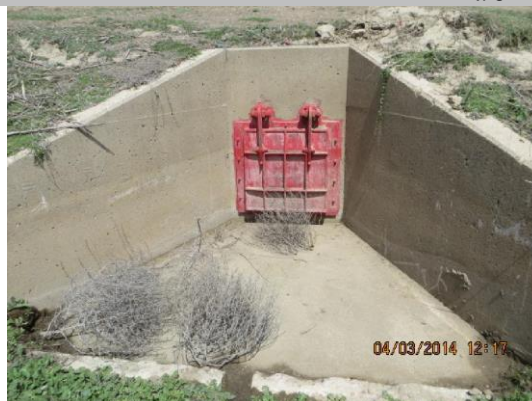
Photo 2 of 3 : UCIP\_SP\_2021\_62191\_59859.jpg

Flapgate on Concrete headwall at WS toe.

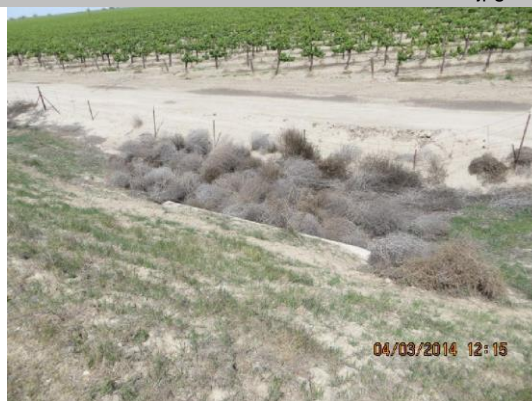
Photo 3 of 3 : UCIP\_SP\_2021\_62191\_59861.jpg

Concrete headwall at LS toe. Excess vegetation buildup at inlet.

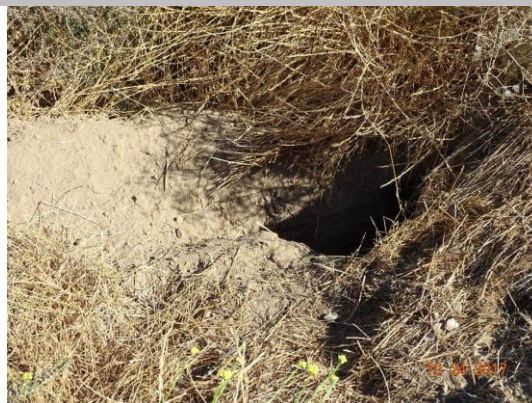
Photo 1 of 1 : SP\_2021\_NA0010\_139\_26\_20210308\_00006.jpg

LM Start	1.09	Rating **	M	Issue No.	26
LM End	1.09	Issue Type +	Ma	Location *	LS
Category	Earthen Levee			GPS Latitude/Longitude	
				Start	End
Item	Animal Control			36.772743 °	36.772743 °
				-120.266800 °	-120.266800 °
DWR ID	DWR_NA0010_23_f _ 2017_26				
Comment Code					
A3 : No rodents visible, but rodent burrows visible; need to backfill and compact or grout burrows.					
Inspector Comment					
Need to repair the large rodent hole on the landside slope.

Looking at the landside slope.

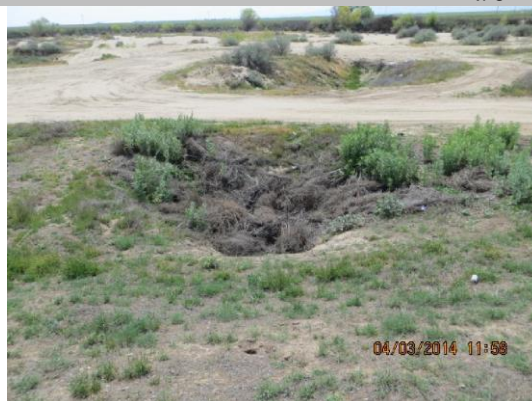
Photo 1 of 3 : UCIP\_SP\_2021\_62194\_59855.jpg

Comment Code						
Inspector Comment						
FS_ID:62194 DS_ID:19948 EP_NO: N/A Repair Type: Non-Urgent Crossing Status: Found UCIP Comments: 04/03/2014 Appears abandoned and if so should be done properly. Discharge channel is blocked by sand and soil making drain ineffective. Soil buildup at inlet on LS toe. Need to contact owner. (W. Wylie - DWR UCIP) FIELD_STRUCT_DESC: 30-inch by 30-inch square reinforced concrete box gravity drainage culvert through the levee, 11 feet below the crown. Flap gate on the waterside (WS) end. Concrete headwall on the landside (LS) end. Concrete U-shaped headwall on the WS end. [Additional Reference(s): DWR Levee Log, 2002 (HLM 1.64), listed as a 30-inch square reinforced concrete box culvert [RCBC]]. FS Date: 4/3/2014

Concrete headwall on WS toe.

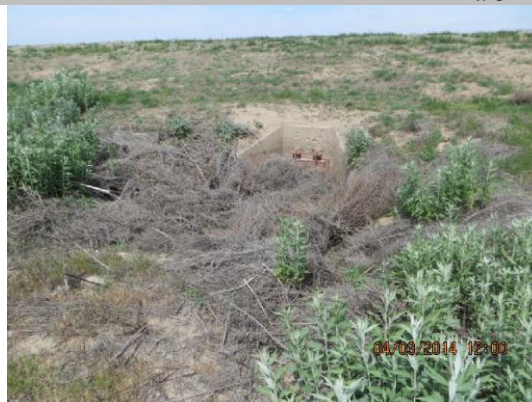
Photo 2 of 3 : UCIP\_SP\_2021\_62194\_59857.jpg

Flapgate on Concrete headwall at WS toe.

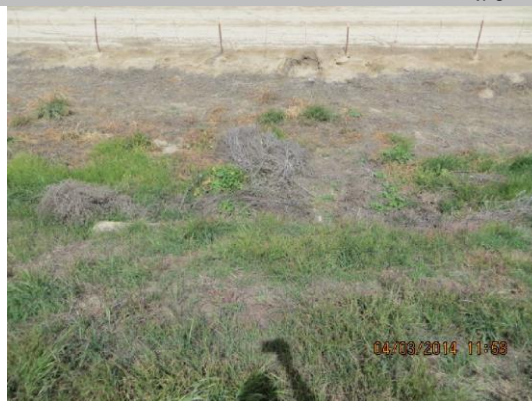
Photo 3 of 3 : UCIP\_SP\_2021\_62194\_59856.jpg

Concrete headwall on LS toe.

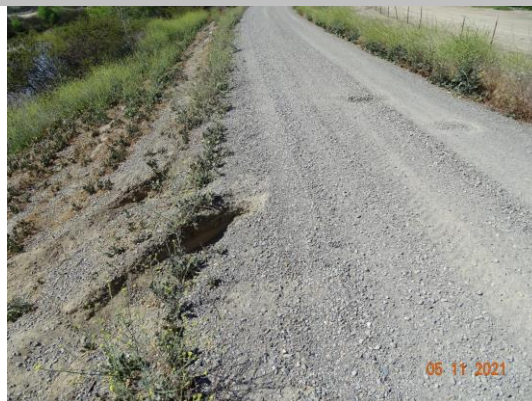
Photo 1 of 1 : SP\_2021\_NA0010\_139\_28\_20210520\_00041.jpg

LM Start	1.90	Rating **	U	Issue No.	28
LM End	1.90	Issue Type +	Ma	Location *	WS
Category	Earthen Levee			GPS Latitude/Longitude	
				Start	End
Item	Slope Stability			36.772731 °	36.772731 °
				-120.253590 °	-120.253590 °
DWR ID	DWR_NA0010_23_s_2021_28				
Comment Code					
S3 : Repair the levee slope damaged by vehicle traffic and prevent access where possible.					
Inspector Comment

View of damage to the waterside slope and shoulder. (Spring 2021)

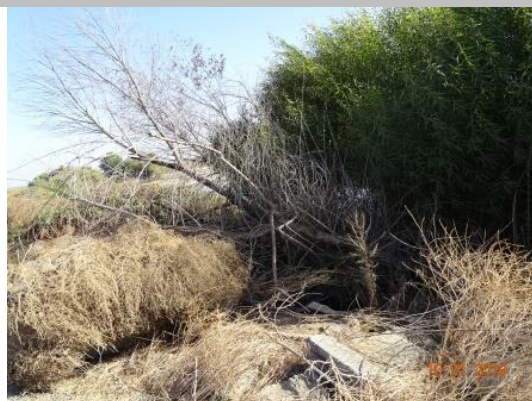
Photo 1 of 1 : SP\_2021\_NA0010\_139\_1\_20210308\_00001.jpg

LM Start	1.91	Rating **	M	Issue No.	1
LM End	1.91	Issue Type +	Ma	Location *	WS
Category	Earthen Levee			GPS Latitude/Longitude	
				Start	End
Item	Encroachments			36.772943 °	36.772943 °
				-120.253511 °	-120.253511 °
DWR ID	DWR_NA0010_23_s_2015_1				
Comment Code					
TR : Tree or limb					
Inspector Comment					
There is a downed tree on the waterside slope.

View of fallen tree on the waterside slope. (Fall 2019)

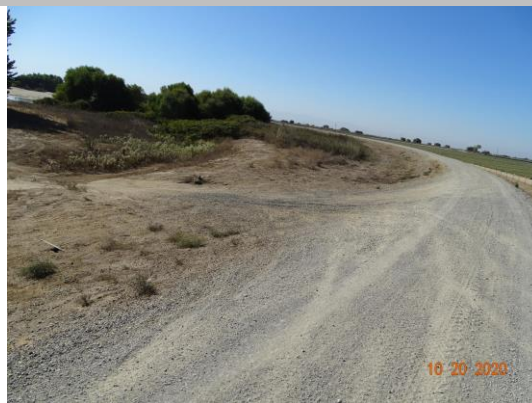
Photo 1 of 1 : SP\_2021\_NA0010\_139\_16\_20210308\_00003.jpg

LM Start	2.12	Rating **	M	Issue No.	16
LM End	2.12	Issue Type +	En	Location *	WS
Category	Earthen Levee			GPS Latitude/Longitude	
				Start	End
Item	Encroachments			36.775507 °	36.775507 °
				-120.251670 °	-120.251672 °
DWR ID	DWR_NA0010_23_s_2013_16				
Comment Code					
RA : Ramp					
Inspector Comment					
Ramp constructed on waterside slope.

View of ramp constructed on waterside slope. (Fall 2020)
