# Flood Control Project Maintenance Levee Inspections LMA District Cover Sheet

## Lower San Joaquin Levee District

**Flood Control Project Maintenance  
Levee Inspections  
Unit Cover Sheet**

Waterway			Bank	Unit Miles
Unit No. 01 San Joaquin River			Right	22.52
	Spring (March - May)	Summer (June - August)	(September - November) Fall	Winter (December - February)
Unit Maintenance Rating (Fall Only)				
Date of Inspection	5/4/2021 - 5/4/2021			
DWR Inspector	Corey Fujitani			
Accompanied By

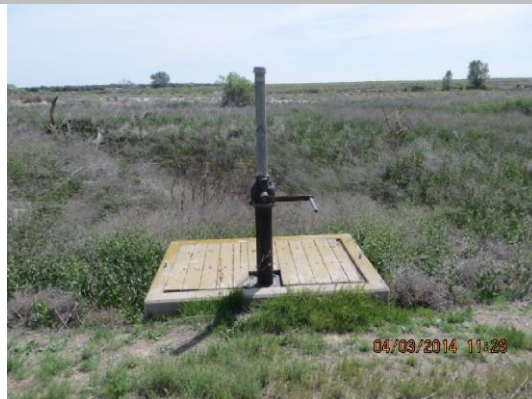
Photo 1 of 3 : UCIP\_SP\_2021\_62197\_59848.jpg

Comment Code						
Inspector Comment						
FS_ID:62197 DS_ID:19953 EP_NO: N/A Repair Type: Non-Urgent Crossing Status: Found UCIP Comments: 04/03/2014 Heavy vegetation at inlet and outlet-- recommend clearing. (W. Wylie - DWR UCIP) FIELD_STRUCT_DESC: 30-inch by 30-inch square reinforced concrete box gravity irrigation culvert through the levee, 10.7 feet below the crown. 4.5-foot by 7-foot concrete riser with slide gate on the waterside (WS) slope. Concrete U-shaped headwall on each end. 15-foot-long cobble revetted inlet channel. [Additional Reference(s): DWR Levee Log, 2002 (HLM 4.87), listed as a 30-inch square reinforced concrete box culvert (RCBC)]. FS Date: 4/3/2014

Slide gate in concrete riser on WS shoulder.

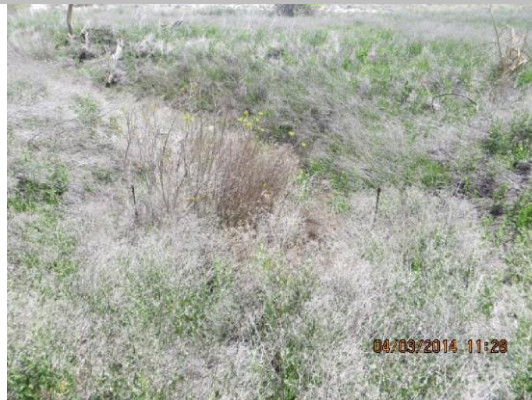
Photo 2 of 3 : UCIP\_SP\_2021\_62197\_59847.jpg

Heavy vegetation in outlet/channel on WS toe.

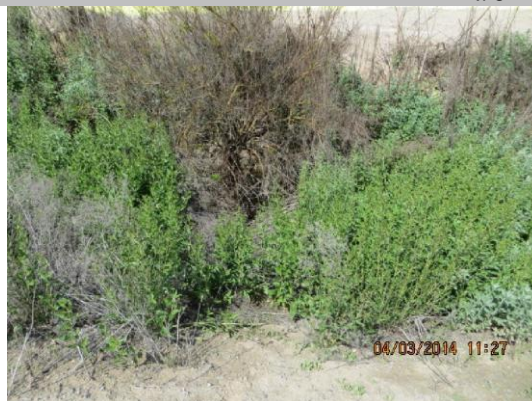
Photo 3 of 3 : UCIP\_SP\_2021\_62197\_59849.jpg

Heavy vegetation at concrete inlet on LS toe.

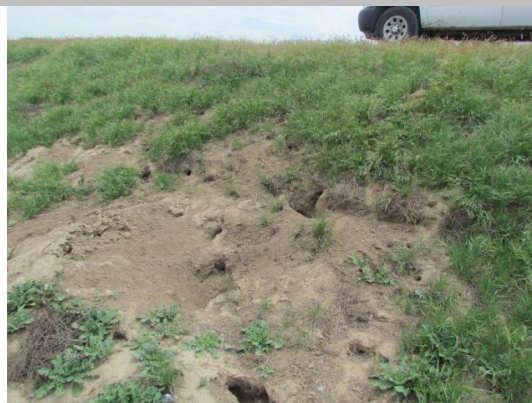
Photo 1 of 1 : SP\_2021\_NA0010\_139\_5\_20210308\_00002.jpg

LM Start	5.68	Rating **	M	Issue No.	5
LM End	5.68	Issue Type +	Ma	Location *	LS
Category	Earthen Levee			GPS Latitude/Longitude	
				Start	End
Item	Animal Control			36.791981 °	36.791981 °
				-120.206274 °	-120.206274 °
DWR ID	DWR_NA0010_23_s_2012_5				
Comment Code					
A1 : Exterminate rodents and backfill and compact or grout burrows.					
Inspector Comment					
There are several large rodent holes in this area.

Looking at several rodent holes on landside slope.

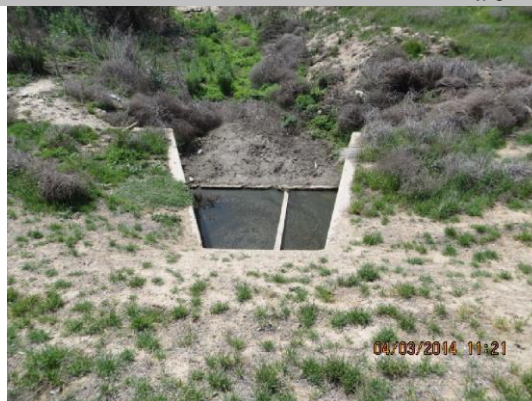
Photo 1 of 3 : UCIP\_SP\_2021\_62198\_59830.jpg

FS\_ID:62198  
DS\_ID:19954  
EP\_NO: N/A  
Repair Type: Non-Urgent  
Crossing Status: Found  
UCIP Comments: 04/03/2014 Dense vegetation limits the inspector's visibility to identify signs of pipe failure (leaks) along the landward slope. Recommend removing vegetation along pipe alignment to conduct proper inspection of structure. (W. Wylie - DWR UCIP)  
FIELD\_STRUCT\_DESC: 36-inch by 36-inch square reinforced concrete box gravity drainage culvert through the levee, 9 feet below the crown. Flap gate on the waterside (WS) end. Concrete U-shaped headwall on each end. 5-foot-long cobble revetted outlet channel. [Additional Reference(s): DWR Levee Log, 2002 (HLM 5.71), listed as a 36-inch square reinforced concrete box culvert (RCBC). USACE San Joaquin O&M Manual, Unit 601 Part 1 (SJR601.1), 1967, Revised 25 May 2011, (HLM 5.71), listed as a 3-foot by 3-foot RCBC]].  
FS Date: 4/3/2014

Concrete headwall on WS toe.

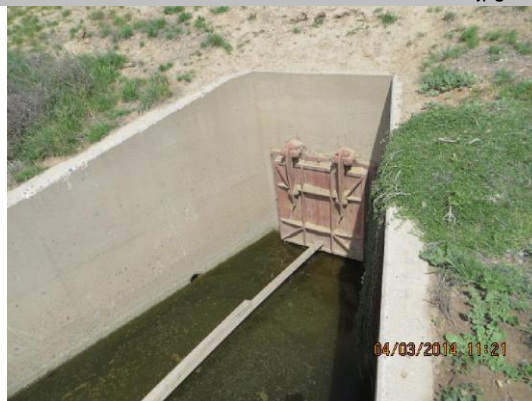
Photo 2 of 3 : UCIP\_SP\_2021\_62198\_59829.jpg

Flapgate on Concrete headwall on WS toe.

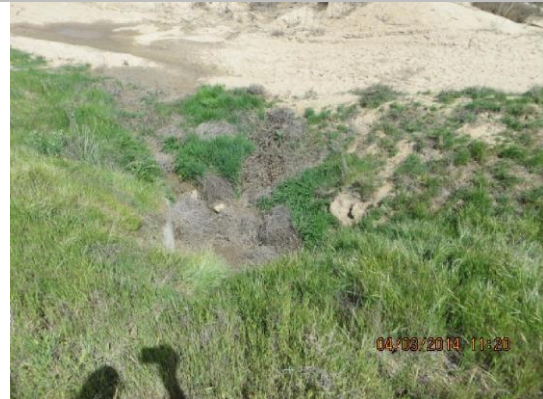
Photo 3 of 3 : UCIP\_SP\_2021\_62198\_59831.jpg

Concrete headwall at LS toe.

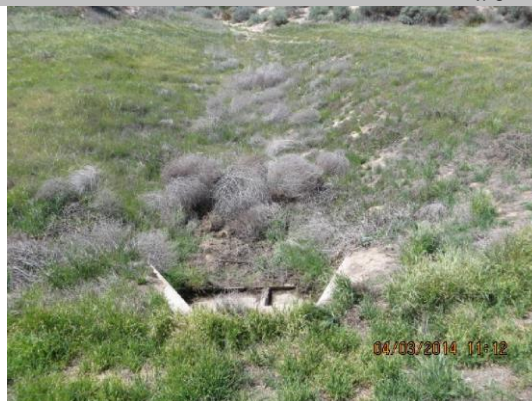
Photo 1 of 3 : UCIP\_SP\_2021\_62199\_59826.jpg

Comment Code						
Inspector Comment						
FS_ID:62199 DS_ID:19939 EP_NO: N/A Repair Type: Non-Urgent Crossing Status: Found UCIP Comments: 04/03/2014 Dense vegetation limits the inspector's visibility to identify signs of pipe failure (leaks) along the landward slope. Recommend removing vegetation along pipe alignment to conduct proper inspection of structure. (W. Wylie - DWR UCIP) FIELD_STRUCT_DESC: 30-inch by 30-inch square reinforced concrete box gravity drainage culvert through the levee, 8.5 feet below the crown. Flap gate on the waterside (WS) end. Concrete headwall on the landside (LS) end. Concrete U-shaped headwall on the WS end. [Additional Reference(s): DWR Levee Log, 2002 (HLM 7.06), listed as a 30-inch square reinforced concrete box culvert (RCBC)]. FS Date: 4/3/2014

Concrete headwall on WS toe.

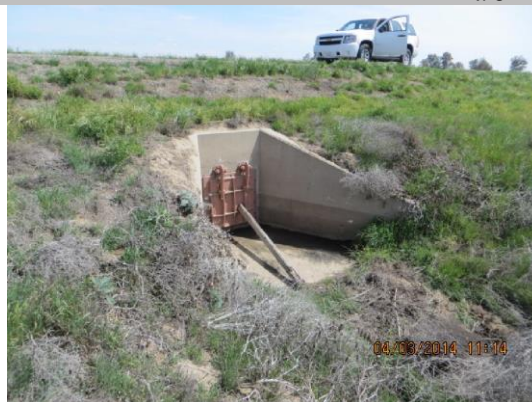
Photo 2 of 3 : UCIP\_SP\_2021\_62199\_59828.jpg

Flapgate on Concrete headwall at WS toe.

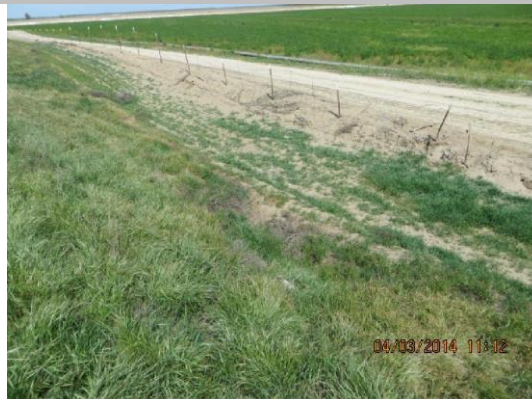
Photo 3 of 3 : UCIP\_SP\_2021\_62199\_59827.jpg

Concrete headwall on LS toe.

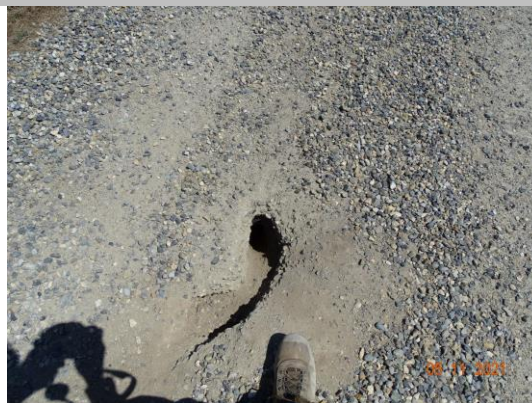
Photo 1 of 1 : SP\_2021\_NA0010\_139\_31\_20210520\_00042.jpg

LM Start	8.32	Rating **	M	Issue No.	31
LM End	8.32	Issue Type +	Ma	Location *	CR
Category	Earthen Levee			GPS Latitude/Longitude	
				Start	End
Item	Animal Control			36.792436 °	36.792436 °
				-120.181289 °	-120.181289 °
DWR ID	DWR_NA0010_23_s_2021_31				
Comment Code					
A3 : No rodents visible, but rodent burrows visible; need to backfill and compact or grout burrows.					
Inspector Comment

View of rodent burrow in the levee crown. (Spring 2021)

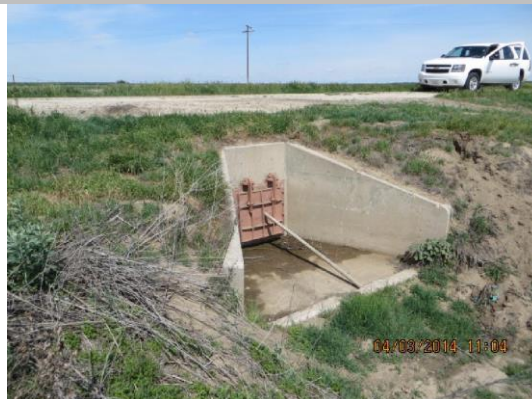
Photo 1 of 3 : UCIP\_SP\_2021\_62200\_59823.jpg

FS\_ID:62200  
DS\_ID:19940  
EP\_NO: N/A  
Repair Type: Non-Urgent  
Crossing Status: Found  
UCIP Comments: 04/03/2014 Some sediment buildup at inlet at LS toe. Also dense vegetation limits the inspector's visibility to identify signs of pipe failure (leaks) along the landward slope. Recommend removing vegetation along pipe alignment to conduct proper inspection of structure. (W. Wylie - DWR UCIP)  
FIELD\_STRUCT\_DESC: 30-inch by 30-inch square reinforced concrete box gravity drainage culvert through the levee, 5.2 feet below the crown. Flap gate on the waterside (WS) end. Concrete headwall on the landside (LS) end. Concrete U-shaped headwall on the WS end.  
[Additional Reference(s): DWR Levee Log, 2002 (HLM 8.33), listed as a 30-inch square reinforced concrete box culvert (RCBC). USACE San Joaquin O&M Manual, Unit 601 Part 1 (SJR601.1), 1967, Revised 25 May 2011, (HLM 8.33), listed as a 2.5-foot by 2.5-foot RCBC]

Flapgate on WS toe.

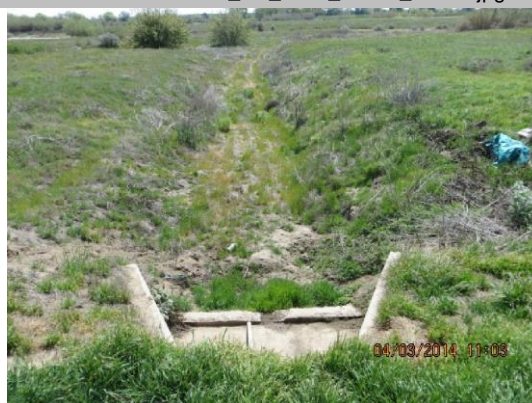
concrete headwall at drainage ditch on WS toe.

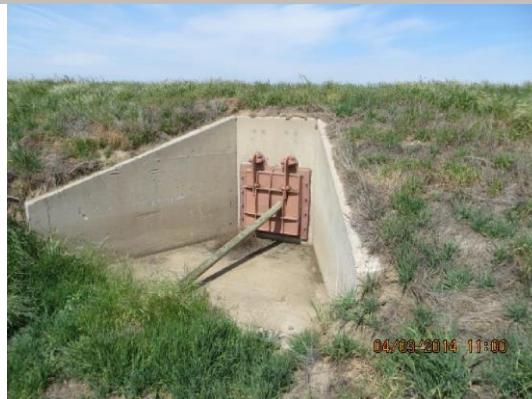
Photo 2 of 3 : UCIP\_SP\_2021\_62201\_59819.jpg

Flapgate on Concrete headwall at WS toe.

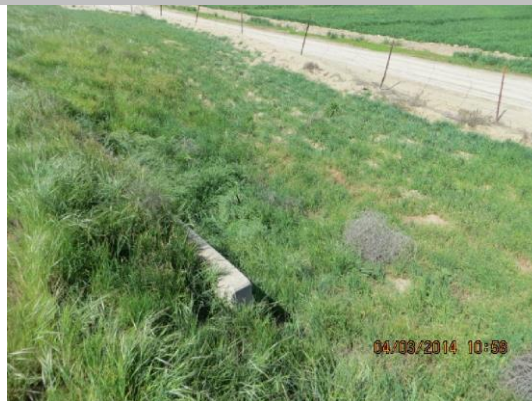
Photo 3 of 3 : UCIP\_SP\_2021\_62201\_59818.jpg

Concrete headwall on LS toe.

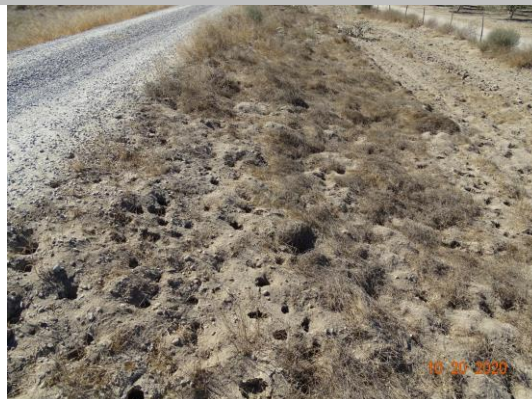
Photo 1 of 1 : SP\_2021\_NA0010\_139\_29\_20210308\_00009.jpg

LM Start	8.55	Rating **	U	Issue No.	29
LM End	8.66	Issue Type +	Ma	Location *	LS
Category	Earthen Levee			GPS Latitude/Longitude	
				Start	End
Item	Animal Control			36.794284 °	36.795288 °
				-120.177783 °	-120.176146 °
DWR ID	DWR_NA0010_23_f_2020_29				
Comment Code					
A3 : No rodents visible, but rodent burrows visible; need to backfill and compact or grout burrows.					
Inspector Comment

Several rodent holes observed along this section of the landside slope.  
(Fall 2020)

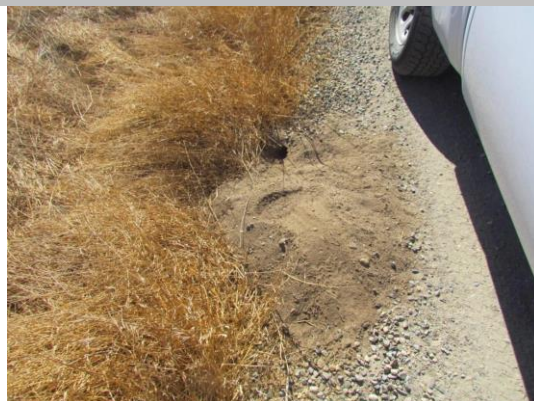
Photo 1 of 1 : SP\_2021\_NA0010\_139\_25\_20210308\_00005.jpg

LM Start	8.97	Rating **	M	Issue No.	25
LM End	8.97	Issue Type +	Ma	Location *	WS
Category	Earthen Levee			GPS Latitude/Longitude	
				Start	End
Item	Animal Control			36.799606 °	36.799606 °
				-120.175395 °	-120.175395 °
DWR ID	DWR_NA0010_23_f_2016_25				
Comment Code					
A3 : No rodents visible, but rodent burrows visible; need to backfill and compact or grout burrows.					
Inspector Comment					
There are rodent holes on the waterside shoulder.

Looking at typical view of rodent hole on waterward shoulder.

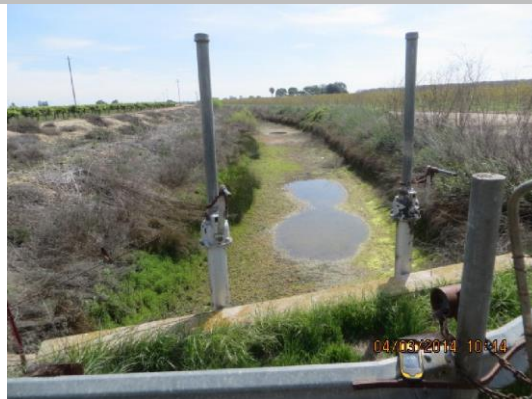
Photo 1 of 3 : UCIP\_SP\_2021\_62205\_59810.jpg

FS\_ID:62205  
DS\_ID:19943  
EP\_NO: N/A  
Repair Type: Non-Urgent  
Crossing Status: Found  
UCIP Comments: 11/01/2018 Limited access to both LS and WS; assumed slide gates are still non-functional; Crossing has been downgraded from Urgent to Non-Urgent due to re-classification of damage slide gates. (O. Magana - DWR UCIP)07/20/2016 No change--same as previous inspection. (O. Magana - DWR UCIP)04/03/2014 Slide gate not functional. Slide gate channels heavily corroded (exfoliated) and likely impact functionality/structural integrity of gate. (W. Wylie - DWR UCIP)  
FIELD\_STRUCT\_DESC: [Gravelly Ford Canal Irrigation Structure] 1 of 2: 48-inch by 63-inch reinforced concrete box gravity irrigation culvert through the levee, 10 feet below the crown. Concrete U-shaped headwall on each end. Gear pedestal slide gate with wall bracket on the waterside (WS) headwall. 10-foot-long cobble revetted outlet channel. Guardrail on each shoulder. Slide gates on the WS. [Additional Reference(s): DWR Levee Log, 2002 (HLM 9.76), listed as a two 4.0-foot by 5.25-foot reinforced concrete box culvert (RCBC). USACE San Joaquin O&M Manual, Unit 601 Part 1 (SJR601.1), 1967, Revised 25 May 2011, (HLM 9.76), listed as a two 5.25-foot by 4-foot barrel RCBC]

Slide gate actuator visible on WS shoulder with concrete headwall.

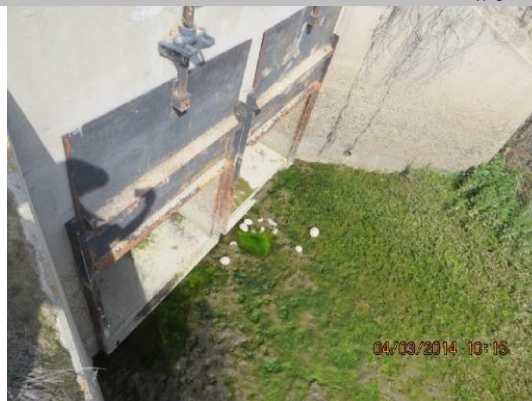
Photo 2 of 3 : UCIP\_SP\_2021\_62205\_59809.jpg

Slide gate on concrete headwall at WS toe.

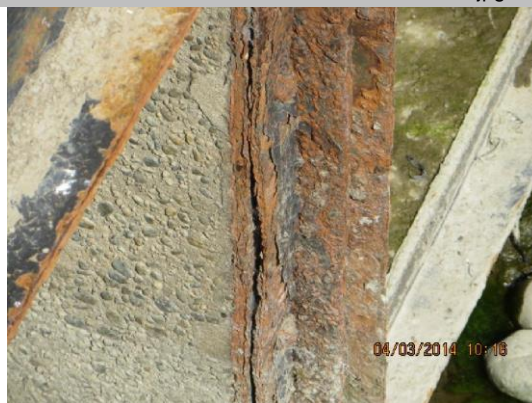
Photo 3 of 3 : UCIP\_SP\_2021\_62206\_59800.jpg

Slide gate tracks show heavy corrosion impacting actuation of slide gate.

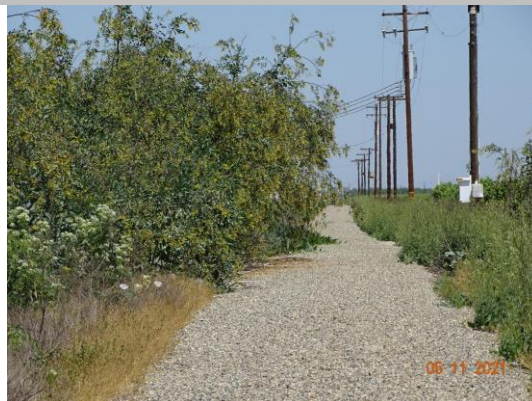
Photo 1 of 1 : SP\_2021\_NA0010\_139\_58\_20210520\_00043.jpg

LM Start	9.79	Rating **	M	Issue No.	58
LM End	9.81	Issue Type +	Ma	Location *	LS
Category	Earthen Levee			GPS Latitude/Longitude	
				Start	End
Item	Trim / Thin Trees			36.808317 °	36.808553 °
				-120.168820 °	-120.168827 °
DWR ID	DWR_NA0010_23_f _ 2018_58				
Comment Code					
T2 : Thin trees to allow visibility of the ground and room to flood fight.					
Inspector Comment					
Woody vegetation is partially blocking crown and landside slope.

Woody vegetation on landside toe obstructing landside of crown. (Spring 2021)

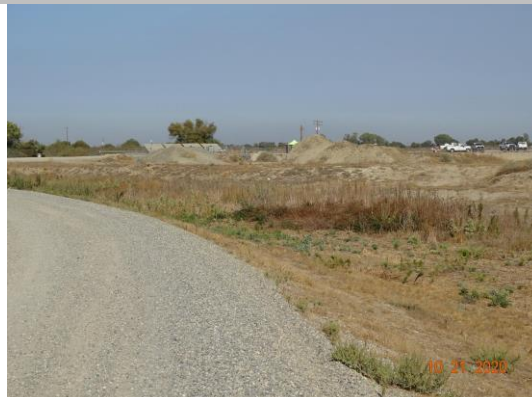
Photo 1 of 1 : SP\_2021\_NA0010\_140\_47\_20210308\_00010.jpg

LM Start	0.06	Rating **	M	Issue No.	47
LM End	0.06	Issue Type +	En	Location *	WS
Category	Earthen Levee			GPS Latitude/Longitude	
				Start	End
Item	Encroachments			36.772328 °	36.772328 °
				-120.285117 °	-120.285117 °
DWR ID	DWR_NA0010_24_s_2014_47				
Comment Code					
MA : Material					
Inspector Comment					
The District constructed a berm on waterside slope. The berm is being used for staging of earthen material.

Berm and material constructed off the waterside slope. (Fall 2020)

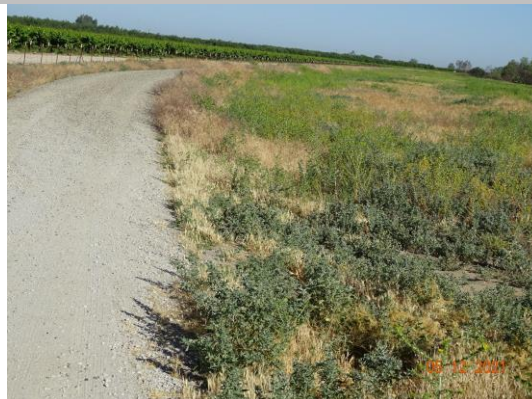
Photo 1 of 1 : SP\_2021\_NA0010\_140\_22\_20210520\_00032.jpg

LM Start	0.07	Rating **	M	Issue No.	22
LM End	7.31	Issue Type +	Ma	Location *	WS
Category	Earthen Levee			GPS Latitude/Longitude	
				Start	End
Item	Vegetation			36.772191 °	36.779554 °
				-120.284987 °	-120.199287 °
DWR ID	DWR_NA0010_24_s_2021_22				
Comment Code					
V1 : Control annual grass and weeds on the levee slopes and easements.					
Inspector Comment

View of the waterside slope looking downstream. (Spring 2021)

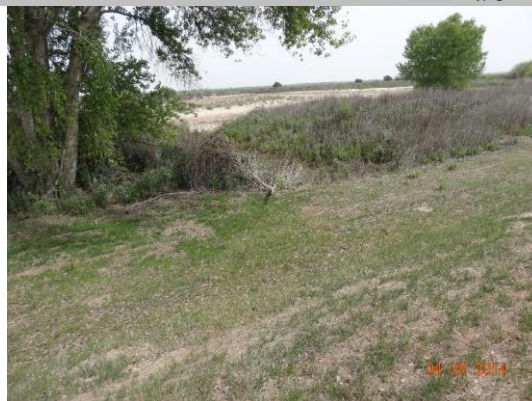
Photo 1 of 3 : UCIP\_SP\_2021\_62209\_60059.jpg

Comment Code						
Inspector Comment						
FS_ID:62209 DS_ID:19955 EP_NO: N/A Repair Type: Non-Urgent Crossing Status: Found UCIP Comments: 04/08/2014 No access available to confirm condition of landward side headwall. Recommend clearing debris along fence. Surface erosion near concrete headwall on landward side was present. (O. Magana - DWR UCIP) FIELD_STRUCT_DESC: 30-inch by 30-inch square reinforced concrete box gravity drainage culvert through the levee, 13.5 feet below the crown. Flap gate on the waterside (WS) end. Concrete headwall on each end. [Additional Reference(s): DWR Levee Log, 2002 (HLM 0.49), listed as a 30-inch square concrete culvert]. FS Date: 4/8/2014

View of waterward side.

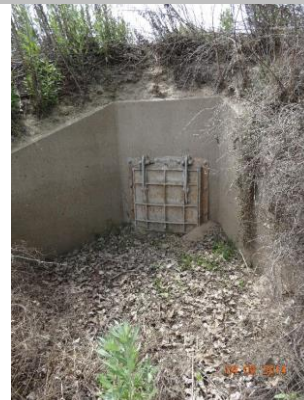
Photo 2 of 3 : UCIP\_SP\_2021\_62209\_60057.jpg

Square gate visible on waterward side.

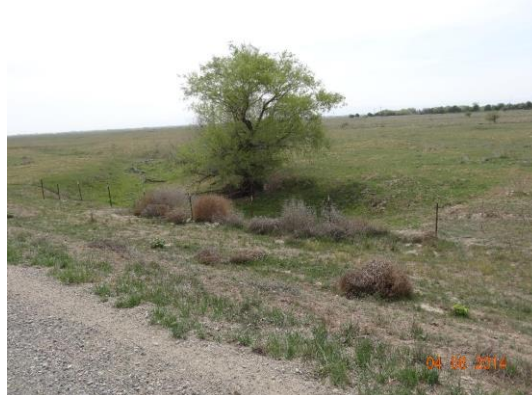
Photo 3 of 3 : UCIP\_SP\_2021\_62209\_60058.jpg

LM Start	<b>0.50</b>	Rating **	M	Issue No.	<b>1 (cont)</b>
LM End	<b>0.50</b>	Issue Type +	En	Location *	
Category	Supplemental		GPS Latitude/Longitude		
			Start	End	
Item	DWR UCIP Field Study		36.766872 °	36.766872 °	
			-120.283212 °	-120.283212 °	
DWR ID	19955

View of landward side.

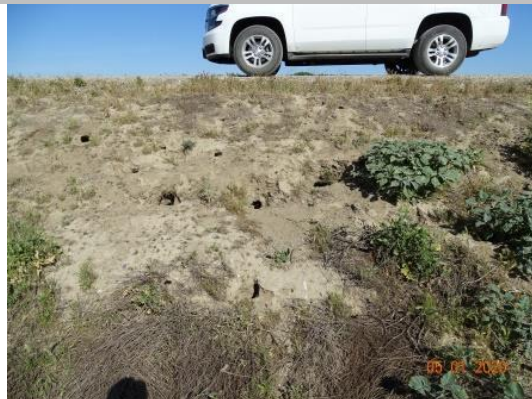
Photo 1 of 1 : SP\_2021\_NA0010\_140\_6\_20210308\_00001.jpg

LM Start	0.80	Rating **	M	Issue No.	6
LM End	0.84	Issue Type +	Ma	Location *	LS
Category	Earthen Levee			GPS Latitude/Longitude	
				Start	End
Item	Animal Control			36.766553 °	36.766962 °
				-120.278947 °	-120.278602 °
DWR ID	DWR_NA0010_24_s_2013_6				
Comment Code					
A1 : Exterminate rodents and backfill and compact or grout burrows.					
Inspector Comment					
There are several rodent holes identified within this section.

Rodent burrows in the landside slope. (Spring 2020)

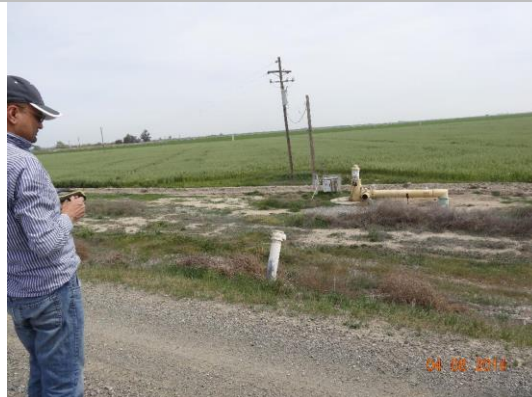
Photo 1 of 2 : UCIP\_SP\_2021\_62210\_60065.jpg

FS\_ID:62210  
DS\_ID:19961  
EP\_NO: 13735  
Repair Type: Non-Urgent  
Crossing Status: Found  
UCIP Comments: 04/08/2014 Unable to determine status of crossing. Need to contact owner to determine status of crossing. (O. Magana - DWR UCIP)  
FIELD\_STRUCT\_DESC: 24-inch coated steel drainage discharge pipe through the levee, 2 feet below the crown. Crown roadway has been padded 1 foot. Steel cutoff wall around the pipe at the centerline of the levee. Pump on the landside (LS). Siphon breaker on the apex of the pipe on the LS shoulder. Galvanized siphon vent pipe on the LS shoulder. (Plans to install two 24-inch steel discharge pipelines through the levee to dispose of seepage water collected in farm sumps Nos. 8 and 12 authorized under Permit No. 13735, 1983 - Rio Seco Farm).  
[Additional Reference(s): DWR Levee Log, 2002 (HLM 1.07), listed as a 24-inch steel pipe].  
FS Date: 4/8/2014

View of landward side.

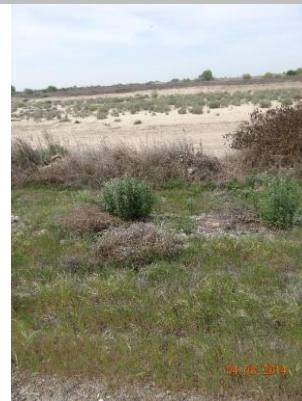
Photo 2 of 2 : UCIP\_SP\_2021\_62210\_60064.jpg

View of waterward side.

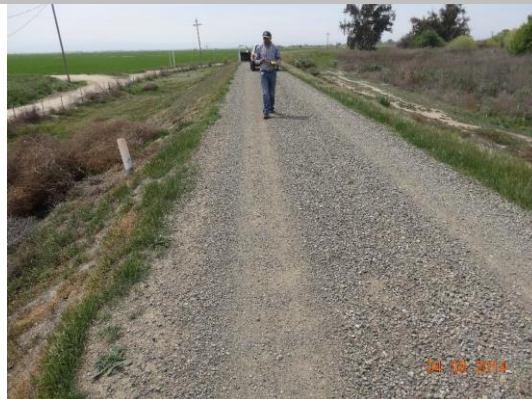
Photo 1 of 3 : UCIP\_SP\_2021\_62211\_60069.jpg

FS\_ID:62211  
DS\_ID:19962  
EP\_NO: 13085  
Repair Type: Non-Urgent  
Crossing Status: Indicator Found  
UCIP Comments: 04/08/2014 Need to contact owner to determine status. (O. Magana - DWR UCIP)  
FIELD\_STRUCT\_DESC: 20-inch coated steel gravity drainage pipe through the levee, 2 feet below the crown. Pipe encased in concrete through the levee crown. Steel cutoff wall around the pipe at each shoulder. Siphon breaker installed on the apex of the pipe on the landside (LS) shoulder. Vent pipe on LS shoulder. Rock riprap on the waterside (WS) slope. (Plans to construct a new discharge structure and to rehabilitate one existing diversion structure to return intercepted seepage to the San Joaquin River authorized under Permit No. 13085, 1981 - Diener, Dry River Farms). [Additional Reference(s): DWR Levee Log, 2002 (HLM 1.75), listed as a 20-inch steel pipe].  
FS Date: 4/8/2014

Overview of levee crown at crossing.

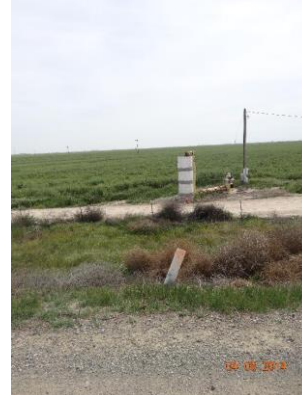
Photo 3 of 3 : UCIP\_SP\_2021\_62211\_60071.jpg

View of landward side.

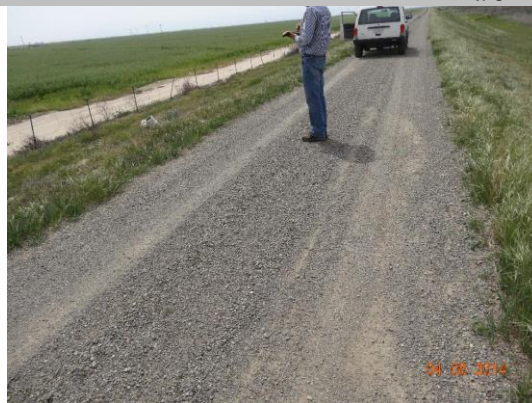
Photo 1 of 3 : UCIP\_SP\_2021\_62212\_60075.jpg

Comment Code					
Inspector Comment					
FS_ID:62212 DS_ID:19963 EP_NO: 13735 Repair Type: Non-Urgent Crossing Status: Found UCIP Comments: 04/08/2014 Unable to confirm status of crossing. (O. Magana - DWR UCIP) FIELD_STRUCT_DESC: 24-inch coated steel drainage discharge pipe through the levee, 2 feet below the crown. Crown roadway has been padded 1 foot. Steel cutoff wall around the pipe at the centerline of the levee. Pump on the landside (LS). Siphon breaker on the apex of the pipe on the LS shoulder. Galvanized siphon vent pipe on the LS shoulder. (Plans to install two 24-inch steel discharge pipelines through the levee to dispose of seepage water collected in farm sumps Nos. 8 and 12 authorized under Permit No. 13735, 1983 - Rio Seco Farm). [Additional Reference(s): DWR Levee Log, 2002 (HLM 2.68) listed as a 24-inch steel pipe]. FS Date: 4/8/2014

Overview of levee crown at crossing.

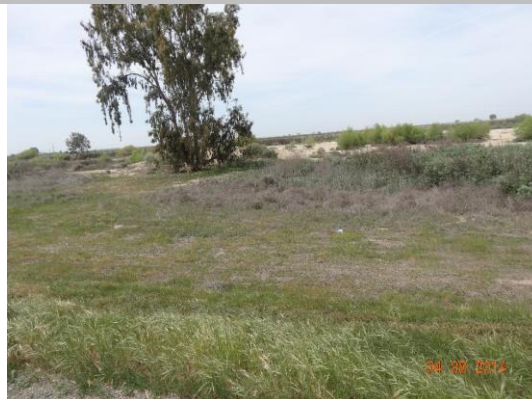
Photo 2 of 3 : UCIP\_SP\_2021\_62212\_60076.jpg

View of waterward side.

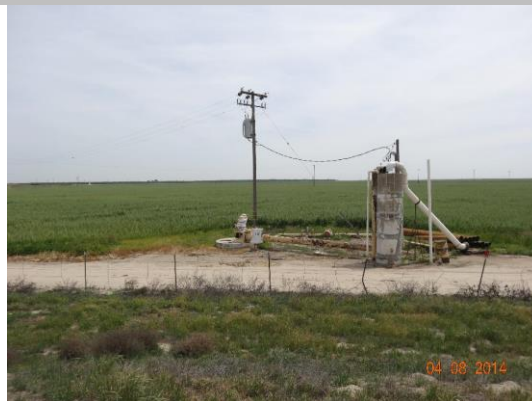
Photo 3 of 3 : UCIP\_SP\_2021\_62212\_60077.jpg

View of landward side.

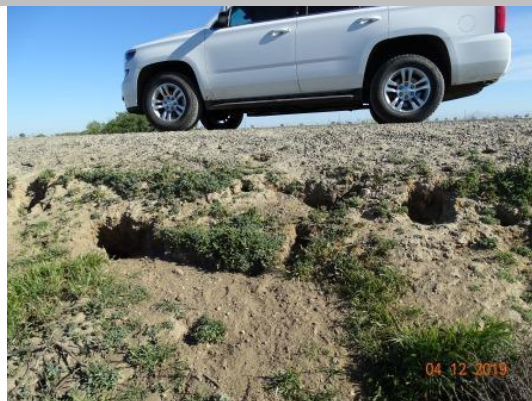
Photo 1 of 1 : SP\_2021\_NA0010\_140\_51\_20210308\_00011.jpg

LM Start	3.05	Rating **	U	Issue No.	51
LM End	3.20	Issue Type +	Ma	Location *	LS
Category	Earthen Levee			GPS Latitude/Longitude	
				Start	End
Item	Animal Control			36.770146 °	36.769796 °
				-120.245703 °	-120.243035 °
DWR ID	DWR_NA0010_24_s_2019_51				
Comment Code					
A3 : No rodents visible, but rodent burrows visible; need to backfill and compact or grout burrows.					
Inspector Comment

View of rodent holes in landside slope. (Spring 2019)

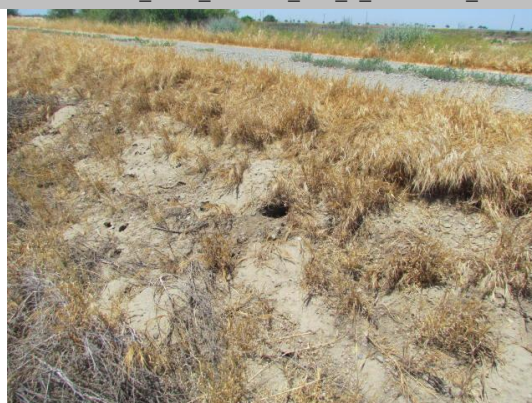
Photo 1 of 1 : SP\_2021\_NA0010\_140\_7\_20210308\_00002.jpg

LM Start	3.46	Rating **	M	Issue No.	7
LM End	3.46	Issue Type +	Ma	Location *	LS
Category	Earthen Levee			GPS Latitude/Longitude	
				Start	End
Item	Animal Control			36.769345 °	36.769345 °
				-120.238370 °	-120.238370 °
DWR ID	DWR_NA0010_24_s_2012_7				
Comment Code					
A3 : No rodents visible, but rodent burrows visible; need to backfill and compact or grout burrows.					
Inspector Comment					
There are several rodent holes on the landside slope.

Looking east at one of several rodent holes on landward slope.

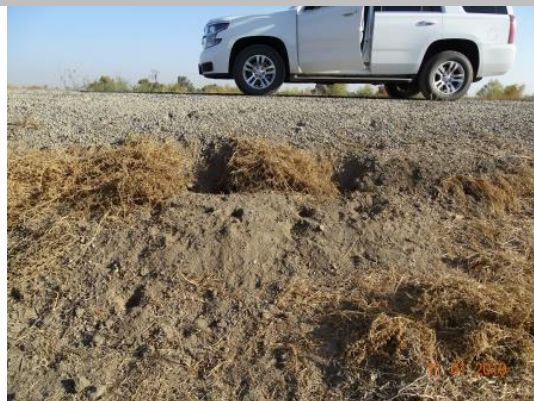
Photo 1 of 1 : SP\_2021\_NA0010\_140\_28\_20210308\_00009.jpg

LM Start	3.53	Rating **	M	Issue No.	28
LM End	3.59	Issue Type +	Ma	Location *	LS
Category	Earthen Levee			GPS Latitude/Longitude	
				Start	End
Item	Animal Control			36.768886 °	36.768531 °
				-120.237154 °	-120.236226 °
DWR ID	DWR_NA0010_24_f_2019_28				
Comment Code					
A3 : No rodents visible, but rodent burrows visible; need to backfill and compact or grout burrows.					
Inspector Comment

View of rodent burrows in the landside slope. (Fall 2019)

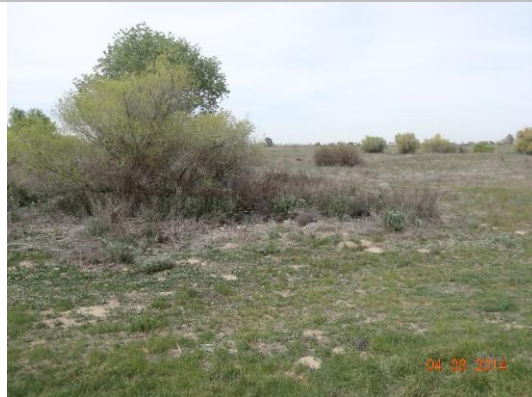
Photo 1 of 3 : UCIP\_SP\_2021\_62213\_67237.jpg

FS\_ID:62213  
DS\_ID:19964  
EP\_NO: N/A  
Repair Type: Non-Urgent  
Crossing Status: Found  
UCIP Comments: 04/08/2014 Unable to confirm crossing alignment and appurtenances associated with this crossing. Multiple stand pipes visible on landward side. Need to contact owner to determine status of crossing and alignment. (O. Magana - DWR UCIP)  
FIELD\_STRUCT\_DESC: 30-inch by 30-inch square reinforced concrete box drainage discharge culvert through the levee, 12.5 feet below the crown. Pump on the landside (LS). Concrete riser with slide gate on the waterside (WS) slope. Screw gate on the LS shoulder. (Plans to construct a new discharge structure and to rehabilitate one existing diversion structure to return intercepted seepage to the San Joaquin River authorized under Permit No. 13085, 1981 - Diener, Dry River Farms). [Additional Reference(s): DWR Levee Log, 2002 (HLM 4.05), listed as a 30-inch square reinforced concrete box culvert (RCBC)].

View of waterward side.

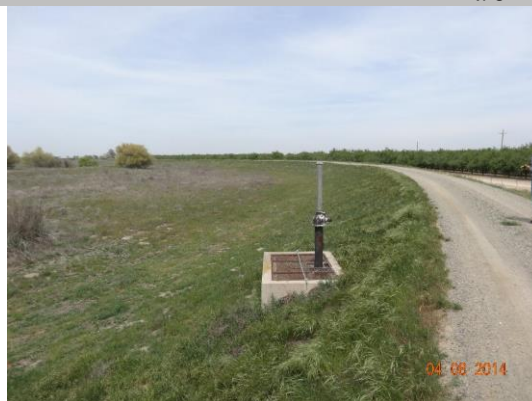
Photo 2 of 3 : UCIP\_SP\_2021\_62213\_67236.jpg

Slide gate inside concrete box located on waterward side.

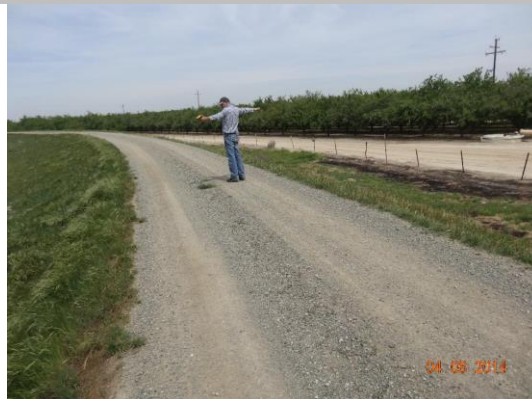
Photo 3 of 3 : UCIP\_SP\_2021\_62213\_67235.jpg

Overview of levee at crossing.

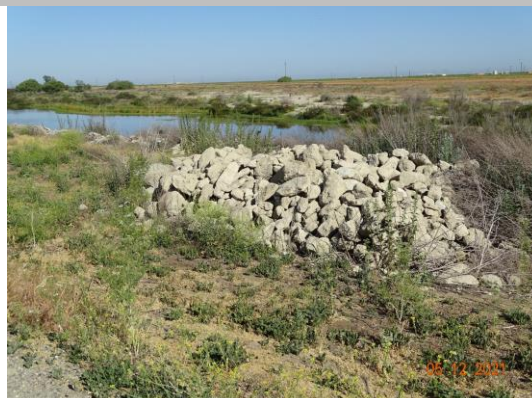
Photo 1 of 1 : SP\_2021\_NA0010\_140\_266\_20210520\_00033.jpg

LM Start	5.30	Rating **	M	Issue No.	266
LM End	5.30	Issue Type +	En	Location *	WS
Category	Earthen Levee			GPS Latitude/Longitude	
				Start	End
Item	Encroachments			36.781960 °	36.781960 °
				-120.224496 °	-120.224496 °
DWR ID	DWR_NA0010_24_s_2015_266				
Comment Code					
MA : Material					
Inspector Comment					
Rocks are stockpiled near the waterside toe.

Stockpile of rock kept in the river channel. (Spring 2021)

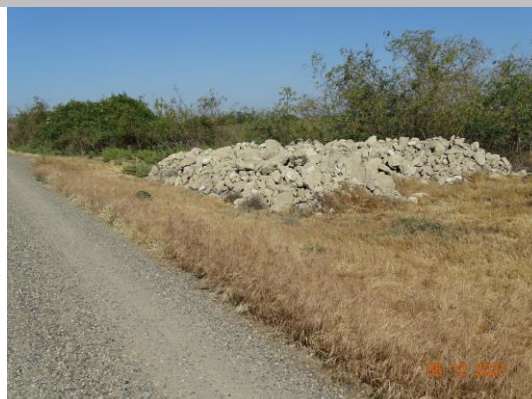
Photo 1 of 1 : SP\_2021\_NA0010\_140\_25\_20210520\_00034.jpg

LM Start	5.40	Rating **	M	Issue No.	25
LM End	5.40	Issue Type +	En	Location *	WS
Category	Earthen Levee			GPS Latitude/Longitude	
				Start	End
Item	Encroachments			36.782397 °	36.782397 °
				-120.222815 °	-120.222815 °
DWR ID	DWR_NA0010_24_s_2021_25				
Comment Code					
MA : Material					
Inspector Comment					
Rocks are stockpiled near the waterside toe.

Stockpile of rock kept at the waterside toe and river channel. (Spring 2021)

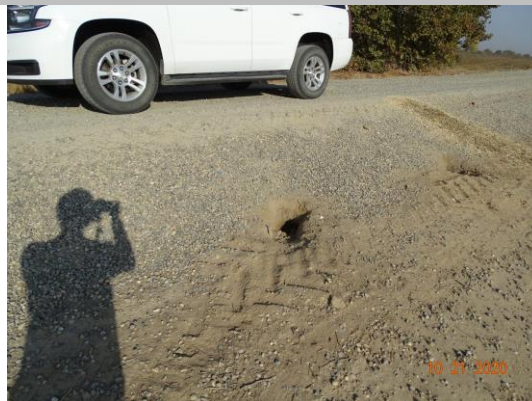
Photo 1 of 1 : SP\_2021\_NA0010\_140\_20\_20210308\_00008.jpg

LM Start	5.66	Rating **	M	Issue No.	20
LM End	5.66	Issue Type +	Ma	Location *	LS
Category	Earthen Levee			GPS Latitude/Longitude	
				Start	End
Item	Animal Control			36.784215 °	36.784215 °
				-120.218882 °	-120.218882 °
DWR ID	DWR_NA0010_24_f_2020_20				
Comment Code					
A3 : No rodents visible, but rodent burrows visible; need to backfill and compact or grout burrows.					
Inspector Comment

Rodent holes at the landside toe. (Fall 2020)

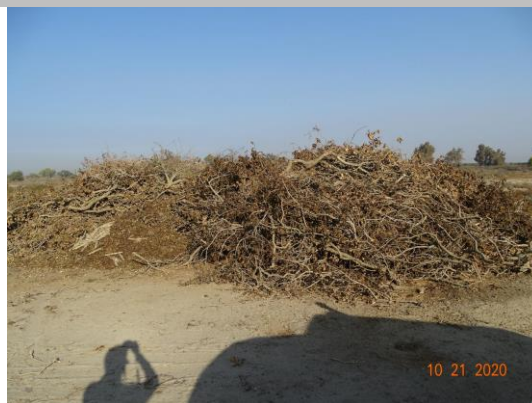
Photo 1 of 1 : SP\_2021\_NA0010\_140\_18\_20210308\_00006.jpg

LM Start	6.34	Rating **	U	Issue No.	18
LM End	6.34	Issue Type +	En	Location *	WS
Category	Earthen Levee			GPS Latitude/Longitude	
				Start	End
Item	Encroachments			36.788192 °	36.788192 °
				-120.209528 °	-120.209528 °
DWR ID	DWR_NA0010_24_f_2020_18				
Comment Code					
PR : Prunings					
Inspector Comment					
Prunings piled on the waterside berm.

Pruning pile left on the waterside toe. (Fall 2020)

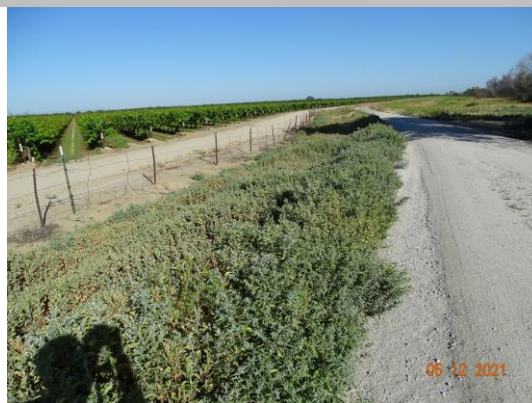
Photo 1 of 1 : SP\_2021\_NA0010\_140\_17\_20210520\_00035.jpg

LM Start	6.72	Rating **	M	Issue No.	17
LM End	7.33	Issue Type +	Ma	Location *	LS
Category	Earthen Levee			GPS Latitude/Longitude	
				Start	End
Item	Vegetation			36.786744 °	36.779355 °
				-120.204756 °	-120.199022 °
DWR ID	DWR_NA0010_24_s_2021_17				
Comment Code					
V1 : Control annual grass and weeds on the levee slopes and easements.					
Inspector Comment

View of vegetation on the landside slope looking downstream. (Spring 2021)

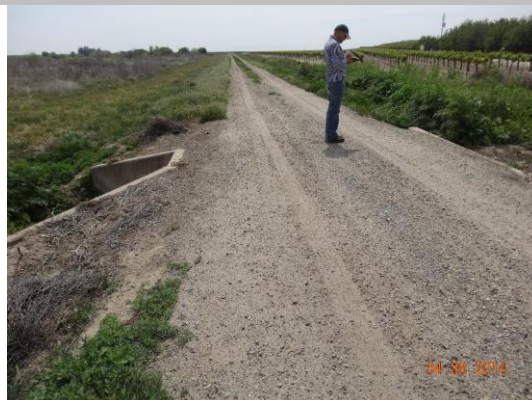
Photo 1 of 3 : UCIP\_SP\_2021\_62215\_60105.jpg

Comment Code						
Inspector Comment						
FS_ID:62215 DS_ID:19957 EP_NO: N/A Repair Type: Non-Urgent Crossing Status: Found UCIP Comments: 7/20/2016 same as previous inspection. Crossing has been downgraded from Urgent to Non-Urgent PVC does not prevent WS flap gate from closing. (O. Magana - DWR UCIP)4/08/2014 Unauthorized PVC pipe through existng crossing. PVC distorted inside--Need to contact owner to correct issue. If crossing was allowed need to contact owner for permit number issue for crossing variance. (O. Magana - DWR UCIP) FIELD_STRUCT_DESC: 24-inch corrugated metal gravity drainage pipe through the levee, 3.6 feet below the crown. Flap gate on the waterside (WS) end. Concrete headwall on the landside (LS) end. Concrete U-shaped headwall on the WS end. [Additional Reference(s): DWR Levee Log, 2002 (HLM 6.72), listed as a 24-inch corrugated metal pipe (CMP)]. FS Date: 7/20/2016

Overview of levee crown at crossing.

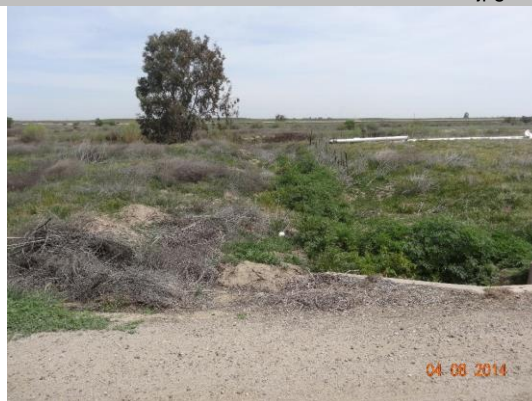
Photo 2 of 3 : UCIP\_SP\_2021\_62215\_60107.jpg

View of WS--debris (pipe sections) located on waterward side.

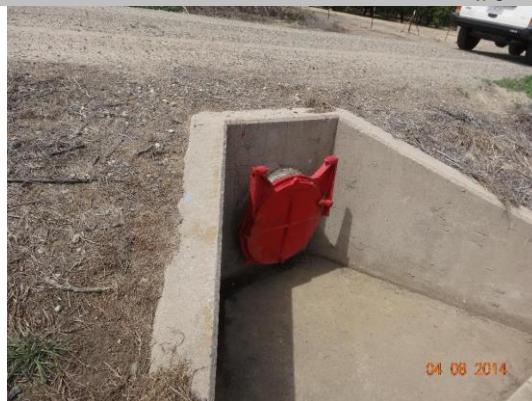
Photo 3 of 3 : UCIP\_SP\_2021\_62215\_60106.jpg

Flap gate visible on WS.

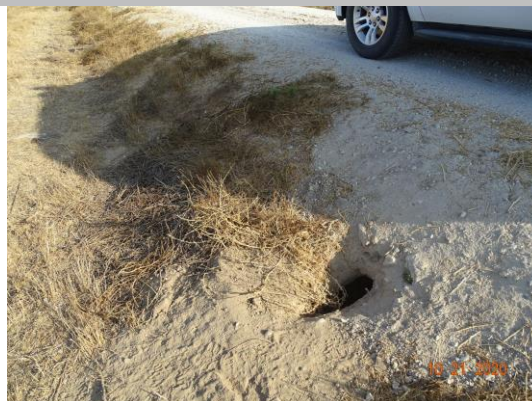
Photo 1 of 1 : SP\_2021\_NA0010\_140\_14\_20210308\_00005.jpg

LM Start	6.86	Rating **	M	Issue No.	14
LM End	6.86	Issue Type +	Ma	Location *	LS
Category	Earthen Levee			GPS Latitude/Longitude	
				Start	End
Item	Animal Control			36.784716 °	36.784716 °
				-120.204043 °	-120.204043 °
DWR ID	DWR_NA0010_24_f_2020_14				
Comment Code					
A3 : No rodents visible, but rodent burrows visible; need to backfill and compact or grout burrows.					
Inspector Comment

Rodent burrow on the landside slope. (Fall 2020)

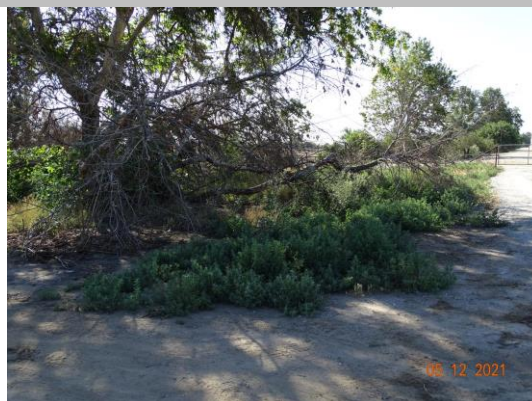
Photo 1 of 1 : SP\_2021\_NA0010\_140\_21\_20210520\_00036.jpg

LM Start	7.33	Rating **	U	Issue No.	21
LM End	7.33	Issue Type +	Ma	Location *	WS
Category	Earthen Levee			GPS Latitude/Longitude	
				Start	End
Item	Encroachments			36.779416 °	36.779416 °
				-120.199091 °	-120.199091 °
DWR ID	DWR_NA0010_24_s_2021_21				
Comment Code					
TR : Tree or limb					
Inspector Comment

Tree limb fallen on the waterside slope. (Spring 2021)

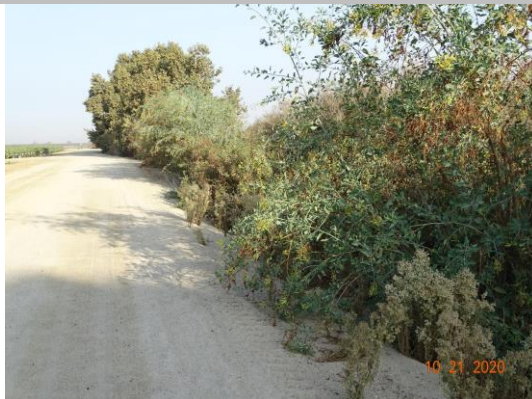
Photo 1 of 1 : SP\_2021\_NA0010\_140\_10\_20210308\_00003.jpg

LM Start	7.35	Rating **	U	Issue No.	10
LM End	7.86	Issue Type +	Ma	Location *	WS
Category	Earthen Levee			GPS Latitude/Longitude	
				Start	End
Item	Vegetation			36.779209 °	36.775239 °
				-120.198886 °	-120.191872 °
DWR ID	DWR_NA0010_24_f_2020_10				
Comment Code					
V2 : Remove the wild growth other than native grasses from the levee slopes.					
Inspector Comment

View of the waterside slope looking downstream. (Fall 2020)

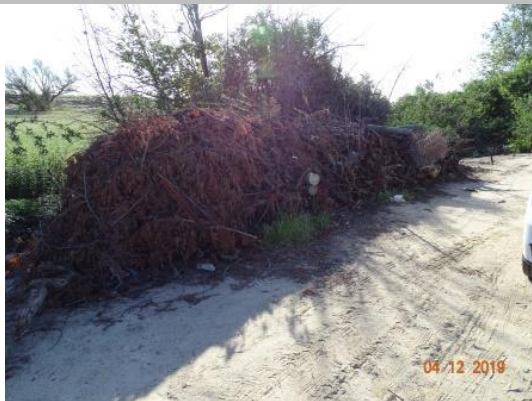
Photo 1 of 1 : SP\_2021\_NA0010\_140\_19\_20210308\_00007.jpg

LM Start	7.38	Rating **	M	Issue No.	19
LM End	7.38	Issue Type +	En	Location *	WS
Category	Earthen Levee			GPS Latitude/Longitude	
				Start	End
Item	Encroachments			36.778838 °	36.778838 °
				-120.198478 °	-120.198478 °
DWR ID	DWR_NA0010_24_s_2019_19				
Comment Code					
TR : Tree or limb					
Inspector Comment

View of tree punings left on waterside shoulder. (Spring 2019)

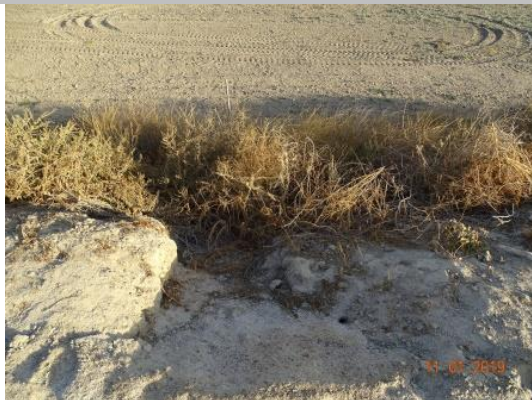
Photo 1 of 1 : SP\_2021\_NA0010\_140\_11\_20210308\_00004.jpg

LM Start	7.83	Rating **	A/W	Issue No.	11
LM End	7.83	Issue Type +	Ma	Location *	WS
Category	Earthen Levee			GPS Latitude/Longitude	
				Start	End
Item	Erosion / Bank Caving			36.775271 °	36.775271 °
				-120.192400 °	-120.192400 °
DWR ID	DWR_NA0010_24_f_2019_11				
Comment Code					
E1 : Note and monitor erosion site.					
Inspector Comment

Looking East down the waterside slope. (Fall 2019)

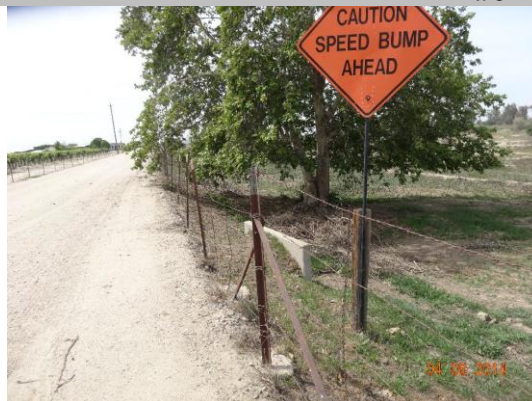
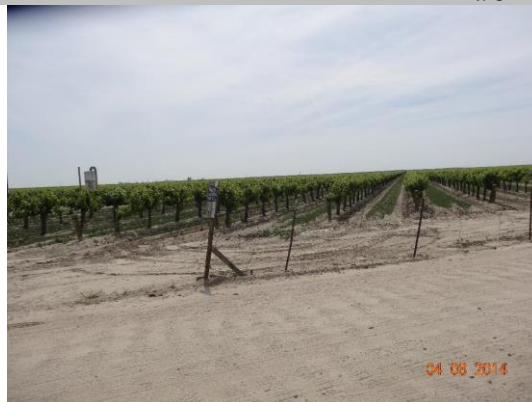
Comment Code						
Inspector Comment						
FS_ID:62218						
DS_ID:19960						
EP_NO: N/A						
Repair Type: Non-Urgent						
Crossing Status: Found						
UCIP Comments: 04/08/2014 Barbed wire along levee shoulder--no access. Need to confirm crossing size and condition of crossing. (O. Magana - DWR UCIP)						
FIELD_STRUCT_DESC: 12-inch reinforced concrete gravity drainage pipe through the levee, 3 feet below the crown. Flap gate on the waterside (WS) end. Concrete headwall on the WS end. [Additional Reference(s): DWR Levee Log, 2002 (HLM 8.33), listed as a 12-inch concrete pipe. USACE San Joaquin O&M Manual, Unit 601 Part 1 (SJR601.1), 1967, Revised 25 May 2011, (HLM 8.32), listed as a 12-inch concrete pipe]						
FS Date: 4/8/2014

View of waterward side.

View of landward side.

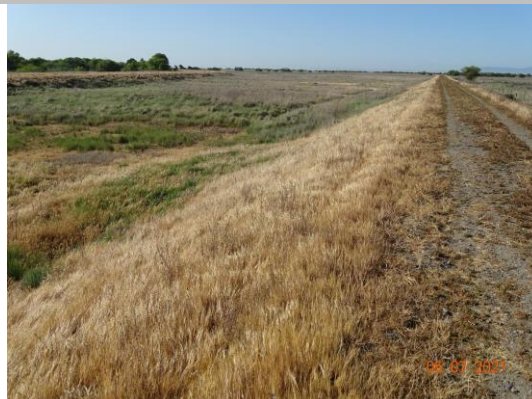
Photo 1 of 1 : SP\_2021\_NA0010\_141\_7\_20210520\_00020.jpg

LM Start	0.01	Rating **	M	Issue No.	7
LM End	2.47	Issue Type +	Ma	Location *	LS
Category	Earthen Levee			GPS Latitude/Longitude	
				Start	End
Item	Vegetation			37.296129 °	37.271355 °
				-120.880745 °	-120.866710 °
DWR ID	DWR_NA0010_25_s_2021_7				
Comment Code					
V1 : Control annual grass and weeds on the levee slopes and easements.					
Inspector Comment

View of the landside slope looking upstream. (Spring 2021)

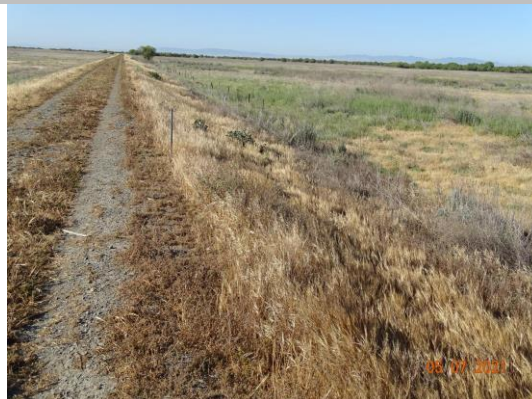
Photo 1 of 1 : SP\_2021\_NA0010\_141\_8\_20210520\_00021.jpg

LM Start	0.01	Rating **	M	Issue No.	8
LM End	2.47	Issue Type +	Ma	Location *	WS
Category	Earthen Levee			GPS Latitude/Longitude	
				Start	End
Item	Vegetation			37.296129 °	37.271347 °
				-120.880745 °	-120.866706 °
DWR ID	DWR_NA0010_25_s_2021_8				
Comment Code					
V1 : Control annual grass and weeds on the levee slopes and easements.					
Inspector Comment

View of vegetation along the waterside slope. (Spring 2021)

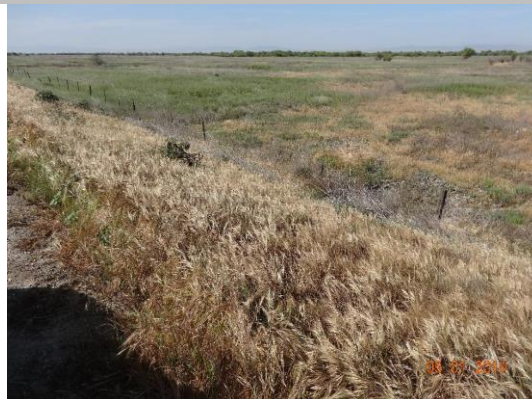
Photo 1 of 3 : UCIP\_SP\_2021\_62225\_67242.jpg

Comment Code						
Inspector Comment						
FS_ID:62225						
DS_ID:19965						
EP_NO: N/A						
Repair Type: Non-Urgent						
Crossing Status: Found						
UCIP Comments: 05/01/2014 Dense vegetation limits the inspectors visibility to identify signs of pipe failure (leaks) along the slope.						
Recommend removing vegetation along pipe alignment to conduct proper inspection of structure. Sediment buildup in pipe visible from landward side--recommend clearing. (O. Magana - DWR UCIP)						
FIELD_STRUCT_DESC: 24-inch corrugated metal gravity drainage pipe through the levee, 10 feet below the crown. Flap gate on the waterside (WS) end. [Additional Reference(s): DWR Levee Log, 2002 (HLM 0.01), listed as a 24-inch corrugated metal pipe (CMP). USACE San Joaquin O&M Manual, Unit 601 Part 1 (SJR601.1), 1967, Revised 25 May 2011, (HLM 0.02), listed as a 24-inch CMP]						
FS Date: 5/1/2014

View of waterward side--dense vegetation on waterward side.

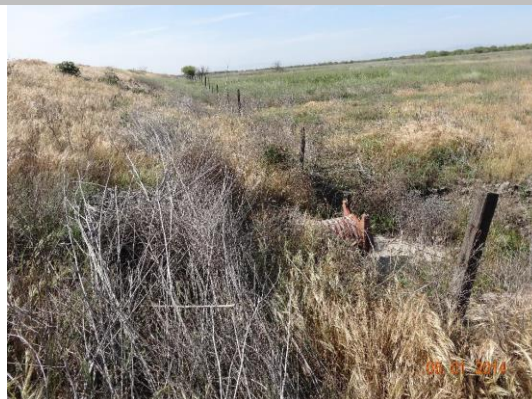
Photo 2 of 3 : UCIP\_SP\_2021\_62225\_67240.jpg

Pipe daylight visible on waterward toe.

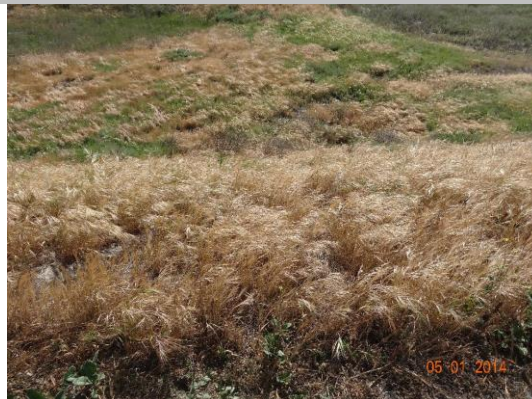
Photo 3 of 3 : UCIP\_SP\_2021\_62225\_67241.jpg

View of landward side--dense vegetation on landward side.

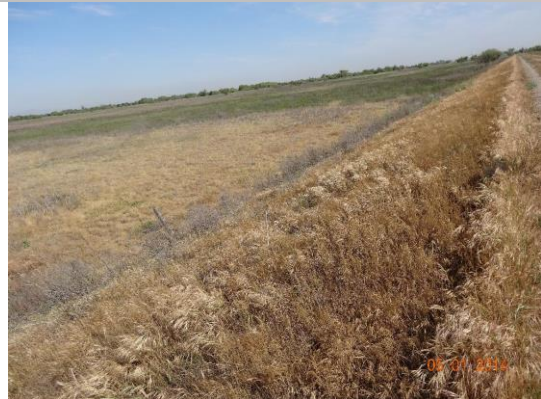
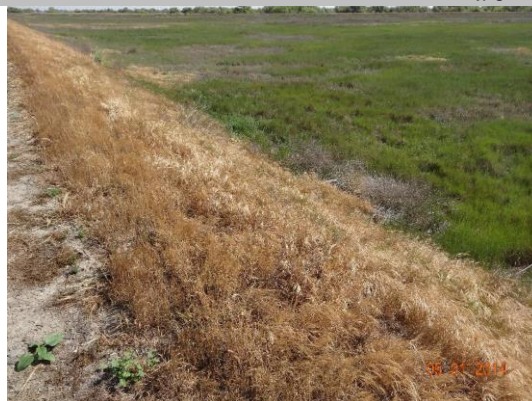
Comment Code						
Inspector Comment						
FS_ID:62220						
DS_ID:19966						
EP_NO: N/A						
Repair Type: Non-Urgent						
Crossing Status: Found						
UCIP Comments: 05/01/2014 Dense vegetation limits the inspectors visibility to identify signs of pipe failure (leaks) along the slope.						
Recommend removing vegetation along pipe alignment to conduct proper inspection of structure. (O. Magana - DWR UCIP)						
FIELD_STRUCT_DESC: 24-inch corrugated metal gravity drainage pipe through the levee, 11.6 feet below the crown. Flap gate on the waterside (WS) end. [Additional Reference(s): DWR Levee Log, 2002 (HLM 0.36), listed as a 24-inch corrugated metal pipe (CMP). USACE San Joaquin O&M Manual, Unit 601 Part 1 (SJR601.1), 1967, Revised 25 May 2011, (HLM 0.35), listed as a 24-inch CMP].						
FS Date: 5/1/2014

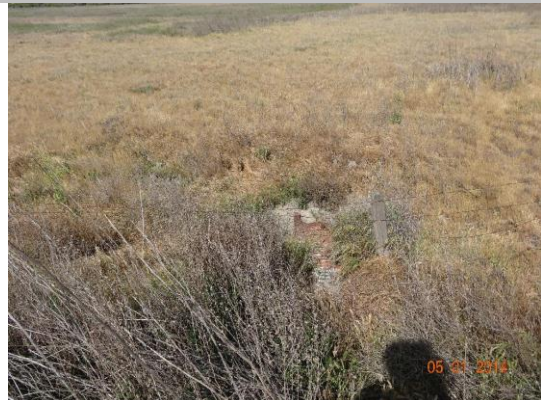
Photo 2 of 3 : UCIP\_SP\_2021\_62220\_67248.jpg

Pipe outlet visible on waterward side.

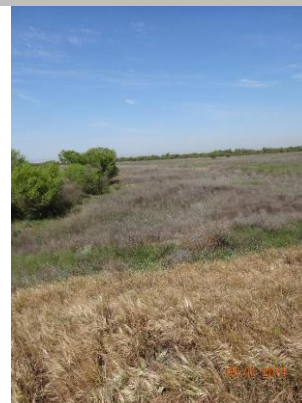
Photo 1 of 3 : UCIP\_SP\_2021\_62221\_67250.jpg

FS\_ID:62221  
 DS\_ID:19967  
 EP\_NO: N/A  
 Repair Type: Non-Urgent  
 Crossing Status: Found  
 UCIP Comments: 05/01/2014 Dense vegetation limits the inspectors visibility to identify signs of pipe failure (leaks) along the slope. Recommend removing vegetation along pipe alignment to conduct proper inspection of structure. (O. Magana - DWR UCIP)  
 FIELD\_STRUCT\_DESC: 24-inch corrugated metal gravity drainage pipe through the levee, 14.7 feet below the crown. Flap gate on the waterside (WS) end. [Additional Reference(s): DWR Levee Log, 2002 (HLM 0.58), listed as a 24-inch corrugated metal pipe (CMP). USACE San Joaquin O&M Manual, Unit 601 Part 1, (SJR601.1), 1967, Revised 25 May 2011, (HLM 0.59), listed as a 24-inch CMP].  
 FS Date: 5/1/2014

Overview of waterward side--Salt Slough.

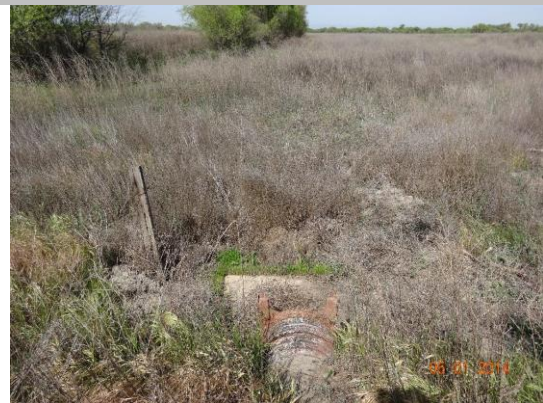
Photo 3 of 3 : UCIP\_SP\_2021\_62221\_67252.jpg

Pipe and flap gate visible on waterward side.

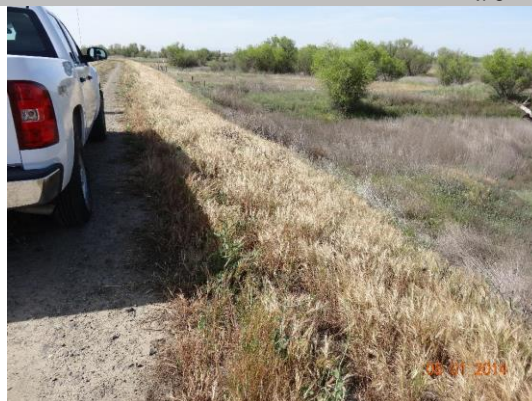
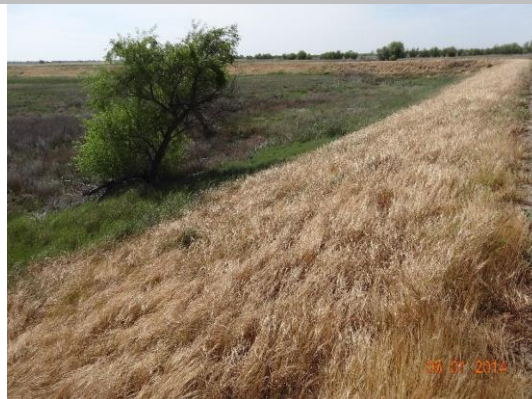
Comment Code						
Inspector Comment						
FS_ID:62222						
DS_ID:19968						
EP_NO: N/A						
Repair Type: Non-Urgent						
Crossing Status: Found						
UCIP Comments: 05/01/2014 Dense vegetation limits the inspectors visibility to identify signs of pipe failure (leaks) along the slope.						
Recommend removing vegetation along pipe alignment to conduct proper inspection of structure. (O. Magana - DWR UCIP)						
FIELD_STRUCT_DESC: 24-inch corrugated metal gravity drainage pipe through the levee, 11.4 feet below the crown. Flap gate on the waterside (WS) end. [Additional Reference(s): DWR Levee Log, 2002 (HLM 0.97), listed as a 24-inch corrugated metal pipe (CMP). USACE San Joaquin O&M Manual, Unit 601 Part 1 (SJR601.1), 1967, Revised 25 May 2011, (HLM 0.97), listed as a 24-inch CMP]						
FS Date: 5/1/2014

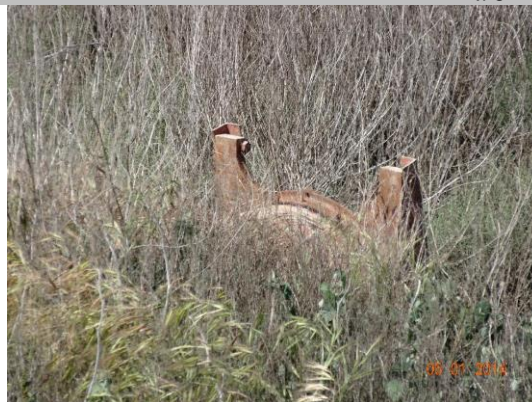
Photo 2 of 3 : UCIP\_SP\_2021\_62222\_67255.jpg

Pipe and evidence of flap gate visible on waterward side.
