# Flood Control Project Maintenance Levee Inspections LMA District Cover Sheet

## Lower San Joaquin Levee District

**Flood Control Project Maintenance  
Levee Inspections  
Unit Cover Sheet**

Waterway			Bank	Unit Miles
Unit No. 01 San Joaquin River			Right	22.52
	Spring (March - May)	Summer (June - August)	(September - November) Fall	Winter (December - February)
Unit Maintenance Rating (Fall Only)				
Date of Inspection	5/4/2021 - 5/4/2021			
DWR Inspector	Corey Fujitani			
Accompanied By

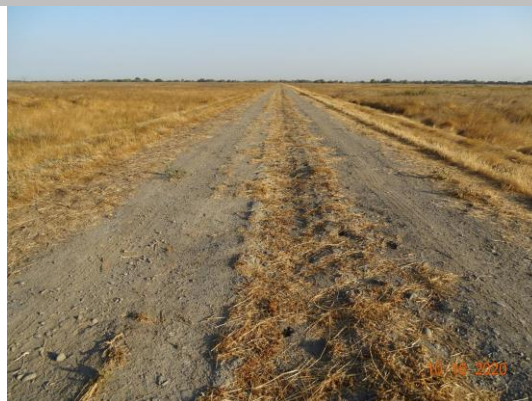
Photo 1 of 1 : SP\_2021\_NA0010\_141\_13\_20210308\_00001.jpg

LM Start	1.00	Rating **	M	Issue No.	13
LM End	2.48	Issue Type +	Ma	Location *	CR
Category	Earthen Levee			GPS Latitude/Longitude	
				Start	End
Item	Crown Surface / Depressions / Rutting			37.281791 °	37.271226 °
				-120.880747 °	-120.866655 °
DWR ID	DWR_NA0010_25_s_2018_13				
Comment Code					
C1 : Add appropriate material and re-grade the levee to bring the crown above the design elevation.					
Inspector Comment

Rutting in the levee crown. (Fall 2020)

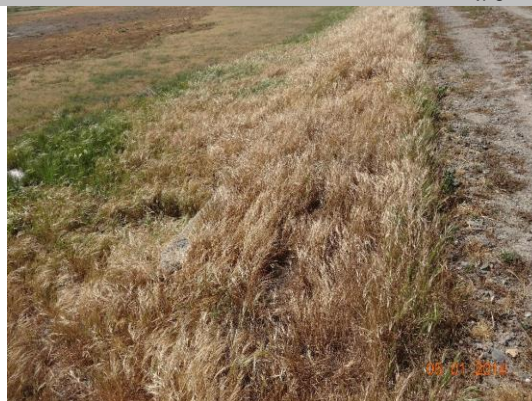
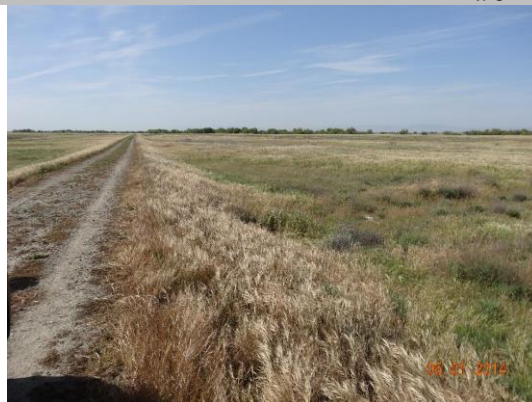
Comment Code						
Inspector Comment						
FS_ID:62223						
DS_ID:19969						
EP_NO: N/A						
Repair Type: Non-Urgent						
Crossing Status: Found						
UCIP Comments: 05/01/2014 Dense vegetation limits the inspectors visibility to identify signs of pipe failure (leaks) along the slope.						
Recommend removing vegetation along pipe alignment to conduct proper inspection of structure. (O. Magana - DWR UCIP)						
FIELD_STRUCT_DESC: 24-inch corrugated metal gravity drainage pipe through the levee, 4 feet below the crown. Flap gate on the waterside (WS) end. [Additional Reference(s): DWR Levee Log, 2002 (HLM 2.05), listed as a 24-inch corrugated metal pipe (CMP). USACE San Joaquin O&M Manual, Unit 601 Part 1 (SJR601.1), 1967, Revised 25 May 2011, (HLM 2.05), listed as a 24-inch CMP]						
FS Date: 5/1/2014

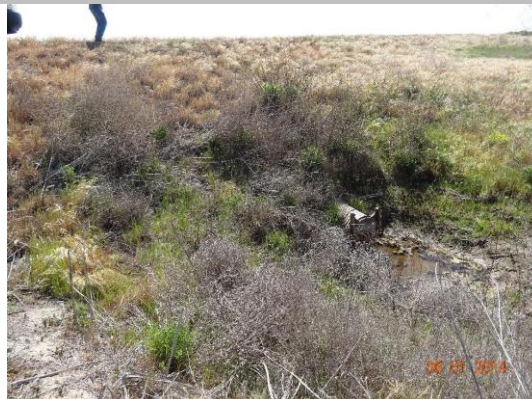
Photo 2 of 3 : UCIP\_SP\_2021\_62224\_67269.jpg

Pipe daylights at waterward toe.
