**Flood Control Project Maintenance
Levee Inspections
LMA District Cover Sheet**

Lower San Joaquin Levee District

**Flood Control Project Maintenance
Levee Inspections
Unit Cover Sheet**

Levee Inspection Report By Mile - Spring 2022

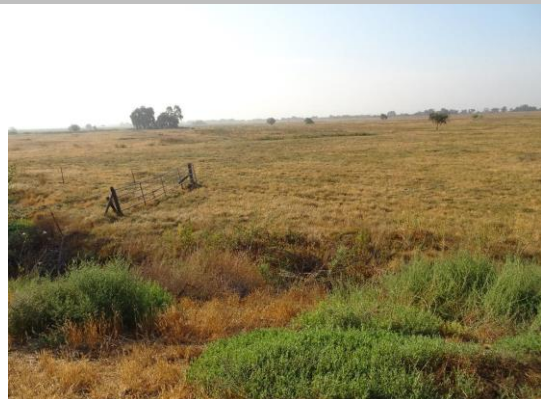
Photo 2 of 3 : UCIP_SP_2022_70636_92088.jpg

LS view: overview of LS, dense vegetation on slope and levee toe.

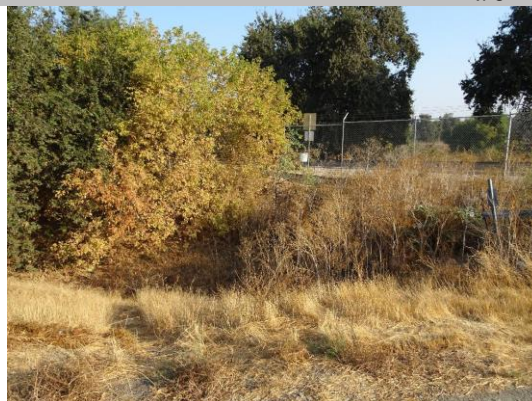
Photo 3 of 3 : UCIP_SP_2022_70636_92087.jpg

WS view: overview of WS, dense vegetation on slope and levee toe.

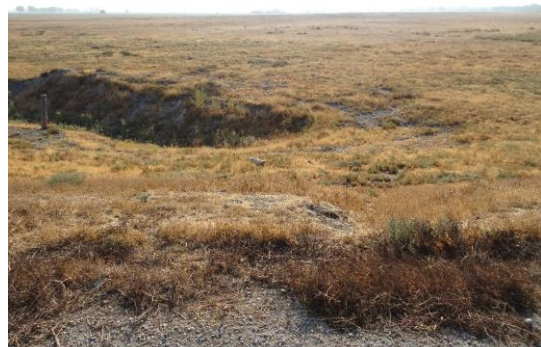
Photo 2 of 3 : UCIP_SP_2022_70637_90530.jpg

LS view: Overview of LS from levee crest, looking US

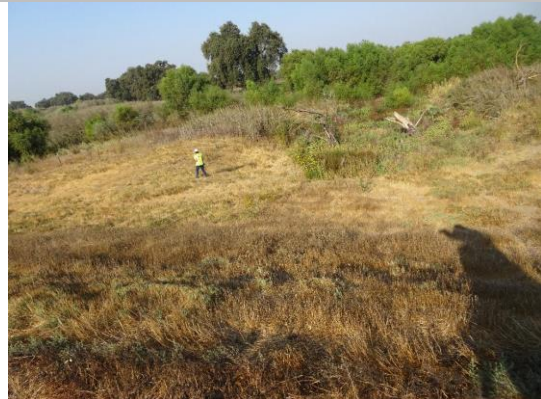
Photo 3 of 3 : UCIP_SP_2022_70637_90531.jpg

WS view: Overview of WS slope, looking US

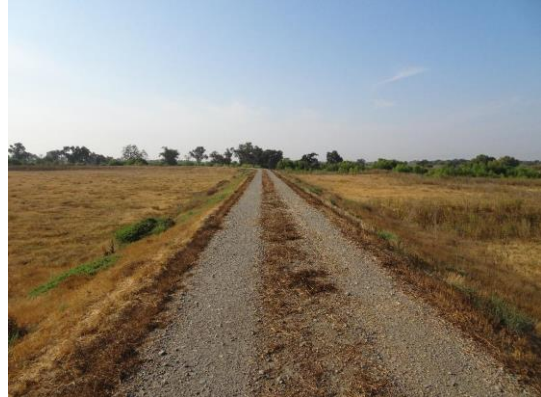
Photo 1 of 3 : UCIP_SP_2022_70638_90537.jpg

FS_ID:70638
DS_ID:19583
EP_NO: N/A
Repair Type: Non-Urgent
Crossing Status: Found
UCIP Comments: 10/06/2020 Record remains Non-Urgent. No permit was found authorizing this encroachment. Rodent activity found near pipe location. CVFPB will need to review crossing to determine owner. DWR DMP has not found internal issues, LOF between 1 and 2. Recommend inspection in 5 years. (B. Singh - GEI, O. Magana - DWR UCIP)04/08/2014 Recommend removing vegetation pile from waterward toe. (W. Wylie - DWR UCIP)
FIELD_STRUCT_DESC: 24-inch corrugated metal (CM) gravity drainage pipe through the levee, 8.5 feet below the crown. Flap gate on the waterside (WS) end. Brass cap No. 108 bench mark (BM) on the headwall on the landside (LS). [Additional Reference(s): DWR Levee Log, 2002, (HLM 0.62). USACE San Joaquin O&M Manual, Unit No. 601, Part No. 1, (SJR601.1), 1967, Revised 25 May 2011, (HLM 0.62)].
FS Date: 10/6/2020

Overview of levee crown, looking US

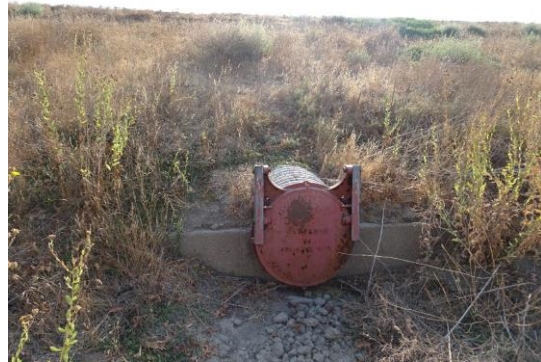
Photo 3 of 3 : UCIP_SP_2022_70638_90535.jpg

WS view: Flapgate and headwall at WS toe

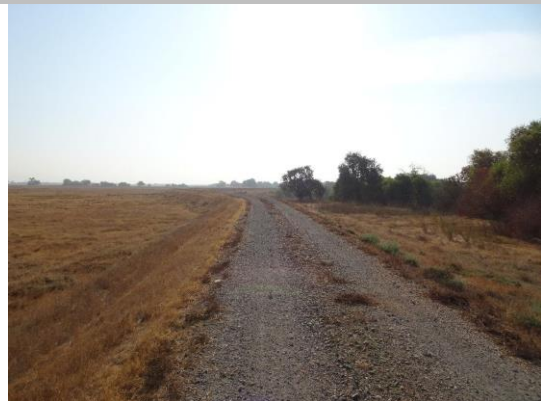
Photo 1 of 3 : UCIP_SP_2022_70639_90541.jpg

FS_ID:70639
DS_ID:19584
EP_NO: N/A
Repair Type: Non-Urgent
Crossing Status: Found
UCIP Comments: 10/06/2020 Record has been updated from No Action Needed to Non-Urgent. No permit was found authorizing this encroachment. CVFPB will need to review crossing to determine owner. Rodent activity found near this stretch of levee. DWR DMP has not found internal issues, LOF between 1 and 2. Recommend inspection in 5 years. (B. Singh - GEI, O. Magana - DWR UCIP)
FIELD_STRUCT_DESC: 24-inch corrugated metal (CM) gravity drainage pipe through the levee, 7.0 feet below the crown. Flap gate on the waterside (WS) end. Brass cap No. 108 bench mark (BM) on the headwall on the landside (LS). [Additional Reference(s): DWR Levee Log, 2002, (HLM 0.88). USACE San Joaquin O&M Manual, Unit No. 601, Part No. 1, (SJR601.1), 1967, Revised 25 May 2011, (HLM 0.87)].
FS Date: 10/6/2020

Overview of levee crown, looking US

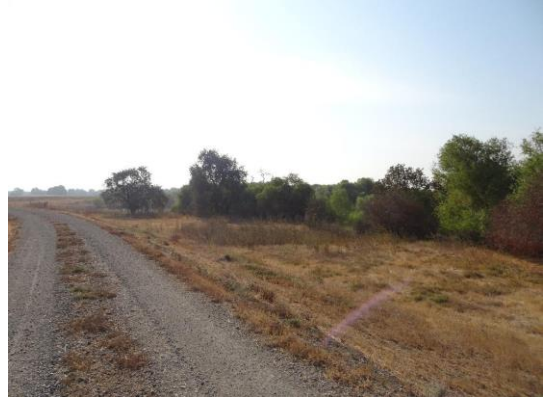
Photo 2 of 3 : UCIP_SP_2022_70639_92306.jpg

WS view: overview of WS looking upstream towards pipe crossing.

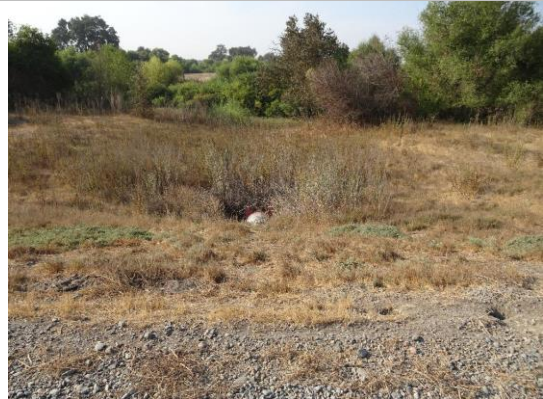
Photo 3 of 3 : UCIP_SP_2022_70639_90542.jpg

WS view: Flapgate and pipe visible on WS toe

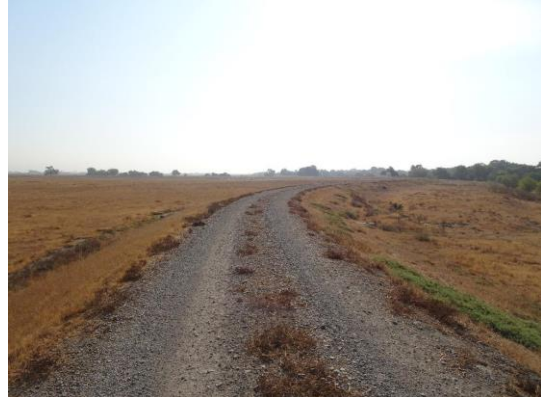
Photo 1 of 3 : UCIP_SP_2022_70640_90550.jpg

FS_ID:70640
DS_ID:19585
EP_NO: N/A
Repair Type: Urgent
Crossing Status: Found
UCIP Comments: 10/06/2020 Record has been updated from Non-Urgent to Urgent. DWR DMP has found integrity issues, LOF between 5 and 6. Scour visible behind the concrete headwall on the LS toe. Recommend monitoring crossing until funding becomes available to addressed. No permit was found authorizing this encroachment. CVFPB will need to review crossing to determine owner. (B. Singh - GEI, O. Magana - DWR UCIP)04/08/2014 Moderate erosion around headwall on landward toe. May or may not be an issue. Need to contact owner to determine status of crossing and to address erosion issue on landward side. (W. Wylie - DWR UCIP)
FIELD_STRUCT_DESC: 24-inch corrugated metal (CM) gravity drainage pipe through the levee, 9.0 feet below the crown. Flap gate on the waterside (WS) end. Brass cap No. 108 bench mark (BM) on the headwall on the landside (LS). [Additional Reference(s): DWR Levee Log, 2002, (HLM 0.96). USACE San Joaquin O&M Manual, Unit No. 601, Part No. 1, (SJR601.1), 1967, Revised 25 May 2011, (HLM 0.95)].

Overview of levee crown, looking US

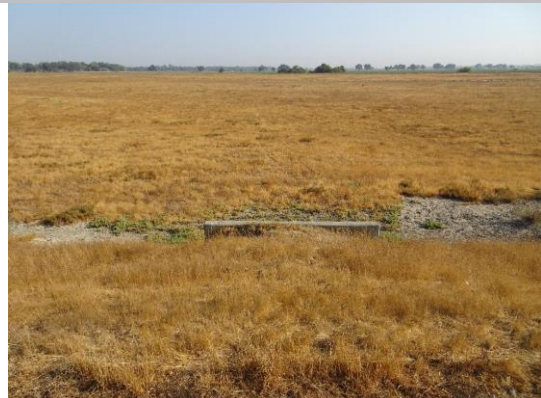
Photo 2 of 3 : UCIP_SP_2022_70640_90552.jpg

LS view: Headwall visible on LS toe

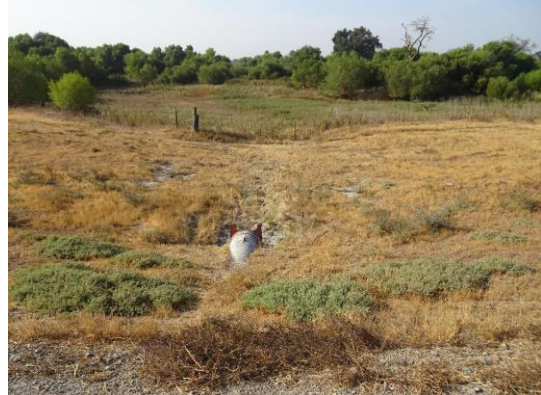
Photo 3 of 3 : UCIP_SP_2022_70640_90551.jpg

WS view: Flapgate, headwall, and pipe visible on WS toe

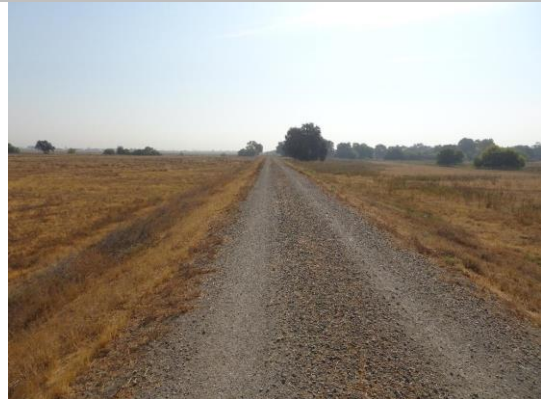
Photo 1 of 3 : UCIP_SP_2022_70641_90554.jpg

FS_ID:70641
 DS_ID:19586
 EP_NO: N/A
 Repair Type: Non-Urgent
 Crossing Status: Found
 UCIP Comments: 10/06/2020 Record has been updated from No Action Needed to Non-Urgent. No permit was found authorizing this encroachment. CVFPB will need to review crossing to determine owner. DWR DMP has not found internal issues, LOF between 1 and 2. Recommend inspection in 5 years. (B. Singh - GEI, O. Magana - DWR UCIP)
 FIELD_STRUCT_DESC: 24-inch corrugated metal (CM) gravity drainage pipe through the levee, 7.5 feet below the crown. Flap gate on the waterside (WS) end. Brass cap No. 108 bench mark (BM) on the headwall on the landside (LS). [Additional Reference(s): DWR Levee Log, 2002, (HLM 1.18). USACE San Joaquin O&M Manual, Unit No. 601, Part No. 1, (SJR601.1), 1967, Revised 25 May 2011, (HLM 1.17)].
 FS Date: 10/6/2020

Overview of levee crown, looking US

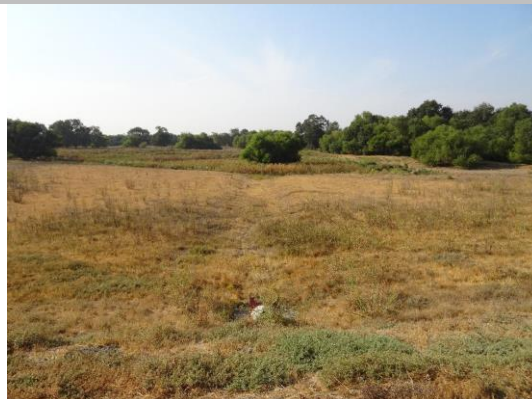
Photo 2 of 3 : UCIP_SP_2022_70641_90555.jpg

Pipe and flapgate visible on WS toe

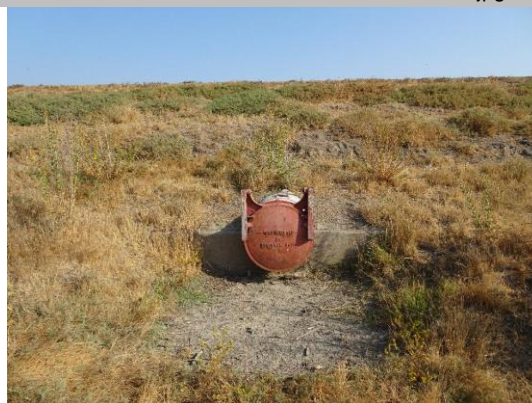
Photo 3 of 3 : UCIP_SP_2022_70641_90553.jpg

Pipe, flapgate and headwall on WS toe

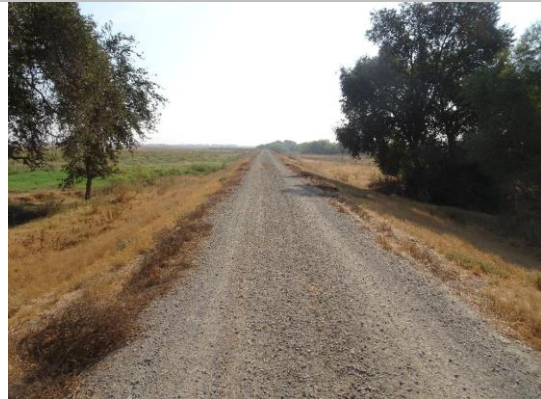
Photo 1 of 3 : UCIP_SP_2022_70642_90560.jpg

FS_ID:70642
DS_ID:19587
EP_NO: N/A
Repair Type: Non-Urgent
Crossing Status: Found
UCIP Comments: 10/06/2020 Record has been updated from No Action Needed to Non-Urgent. No permit was found authorizing this encroachment. CVFPB will need to review crossing to determine owner. DWR DMP internal inspection is still pending and scheduled for 2021. (B. Singh - GEI, O. Magana - DWR UCIP)
FIELD_STRUCT_DESC: 36-inch corrugated metal (CM) gravity drainage pipe through the levee, 12.8 feet below the crown. Flap gate on the waterside (WS) end. Brass cap No. 108 bench mark (BM) on the headwall on the landside (LS). Pipe crosses through the levee at about a 45-degree angle. [Additional Reference(s): DWR Levee Log, 2002, (HLM 1.35). USACE San Joaquin O&M Manual, Unit No. 601, Part No. 1, (SJR601.1), 1967, Revised 25 May 2011, (HLM 1.34)].
FS Date: 10/6/2020

Overview of levee crown, looking US

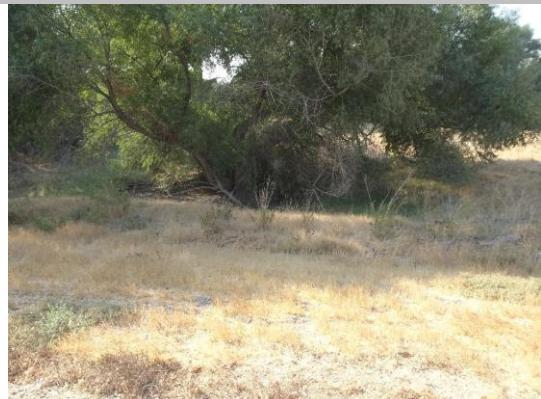
Photo 2 of 3 : UCIP_SP_2022_70642_90565.jpg

WS view: Overview of WS from levee crown. Headwall not visible from levee crown

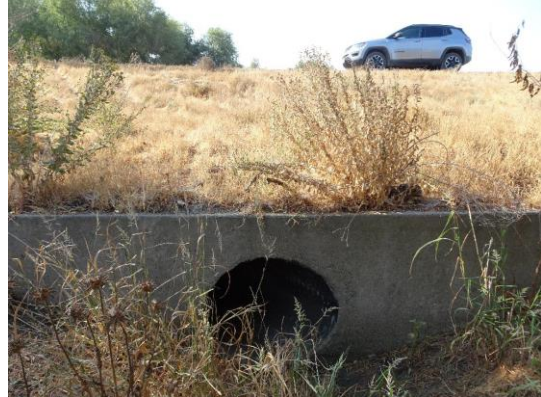
Photo 3 of 3 : UCIP_SP_2022_70642_90561.jpg

LS view: Concrete headwall and pipe visible at LS toe

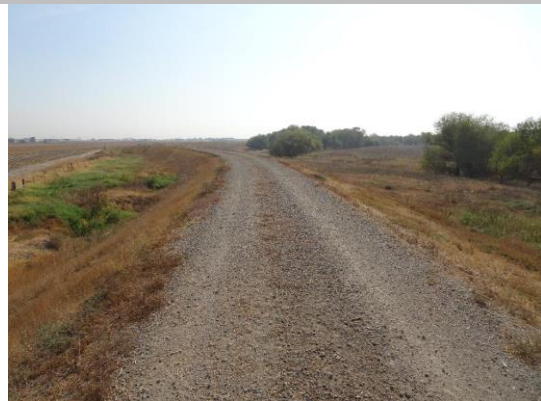
Photo 1 of 3 : UCIP_SP_2022_70643_90567.jpg

FS_ID:70643
DS_ID:19588
EP_NO: N/A
Repair Type: Non-Urgent
Crossing Status: Found
UCIP Comments: 10/06/2020 Record remains Non-Urgent. No permit was found authorizing this encroachment. CVFPB will need to review crossing to determine owner. DWR DMP has not found internal issues, LOF between 1 and 2. Recommend inspection in 5 years. (B. Singh - GEI, O. Magana - DWR UCIP)04/08/2014 Some sediment buildup inside pipe at LS toe. Recommend contacting owner to clear sediment buildup and check wall integrity through pipe section. (W. Wylie - DWR UCIP)
FIELD_STRUCT_DESC: 24-inch corrugated metal (CM) gravity drainage pipe through the levee, 11.0 feet below the crown. Flap gate on the waterside (WS) end. Brass cap No. 108 bench mark (BM) on the headwall on the landside (LS). [Additional Reference(s): DWR Levee Log, 2002, (HLM 1.48). USACE San Joaquin O&M Manual, Unit No. 601, Part No. 1, (SJR601.1), 1967, Revised 25 May 2011, (HLM 1.48)].

Overview of levee crown, looking US

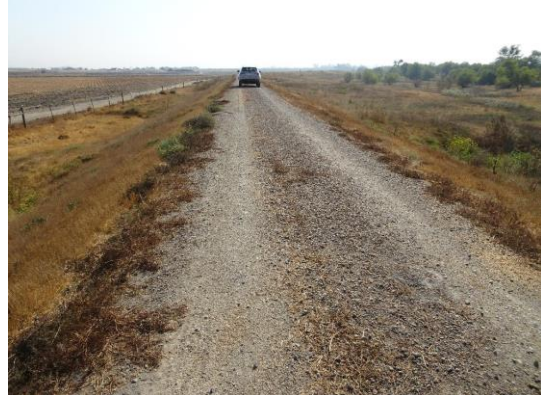
Photo 1 of 3 : UCIP_SP_2022_70644_90572.jpg

Comment Code						
Inspector Comment						
FS_ID:70644 DS_ID:19589 EP_NO: N/A Repair Type: Non-Urgent Crossing Status: Found UCIP Comments: 10/06/2020 Record remains Non-Urgent. DWR DMP has found integrity issues, LOF between 4 and 5. Crossing will be monitored until funding becomes available for rehabilitation. No permit was found authorizing this encroachment. CVFPB will need to review crossing to determine owner. Dense vegetation was found along the WS and LS toe. Recommend removing vegetation along the pipe alignment. Based on the 2014 photos, the LS toe appears to be heavily silted up. Recommend removing silt to increase flow capacity and meet pipe design capacity. (B. Singh - GEI, O. Magana - DWR UCIP)04/08/2014 Heavy sediment buildup in pipe at LS toe. (DWR UCIP - W. Wylie) FIELD_STRUCT_DESC: 24-inch corrugated metal (CM) gravity drainage pipe through the levee, 13.6 feet below the crown. Flap gate on the waterside (WS) end. Brass cap No. 108 bench mark (BM) on the headwall on the landside (LS). [Additional Reference(s): DWR Levee Log, 2002, (HLM 1.70). USACE San Joaquin O&M Manual, Unit No. 601, Part No. 1, (SJR601.1), 1967, Revised 25 May 2011, (HLM 1.69)]. FS Date: 10/6/2020

Overview of levee crown, looking US

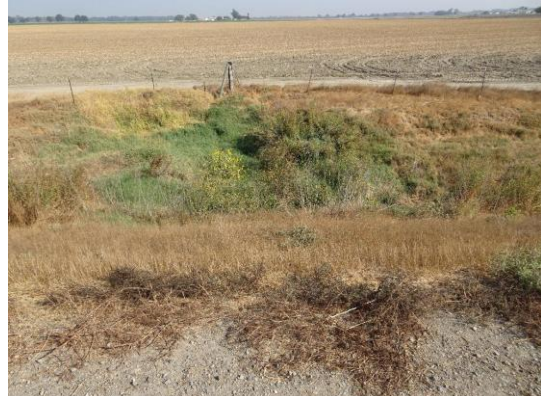
Photo 2 of 3 : UCIP_SP_2022_70644_90573.jpg

LS view: Pipe and headwall not visible on LS toe from levee crown

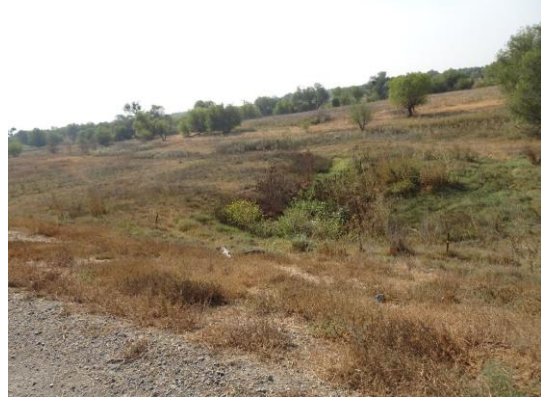
Photo 3 of 3 : UCIP_SP_2022_70644_90574.jpg

WS view: Flapgate and headwall not visible on WS toe from levee crown

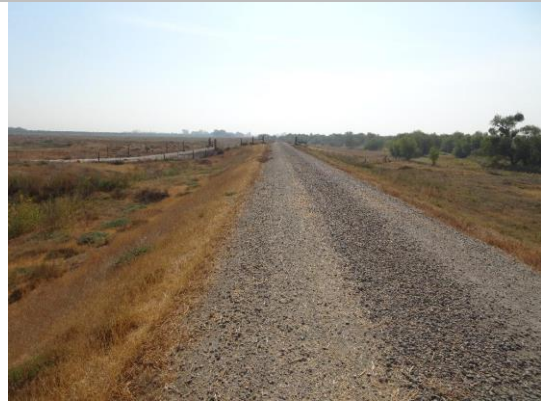
Photo 1 of 3 : UCIP_SP_2022_70645_90581.jpg

Overview of levee crown, looking upstream

Comment Code					
Inspector Comment					
FS_ID:70645 DS_ID:19590 EP_NO: N/A Repair Type: Non-Urgent Crossing Status: Found UCIP Comments: 10/06/2020 Record has been updated from No Action Needed to Non-Urgent. No permit was found authorizing this encroachment. CVFPB will need to review crossing to determine owner. DWR DMP internal inspection is pending and scheduled for 2021. Dense vegetation was observed along the pipe alignment and both WS and LS toe. Recommend clearing vegetation along pipe alignment. (B. Singh - GEI, O. Magana - DWR UCIP) FIELD_STRUCT_DESC: 36-inch corrugated metal (CM) gravity drainage pipe through the levee, 14.2 feet below the crown. Flap gate on the waterside (WS) end. Brass cap No. 100 bench mark (BM) on the headwall on the landside (LS). [Additional Reference(s): DWR Levee Log, 2002, (HLM 1.84). USACE San Joaquin O&M Manual, Unit No. 601, Part No. 1, (SJR601.1), 1967, Revised 25 May 2011, (HLM 1.83)]. FS Date: 10/6/2020

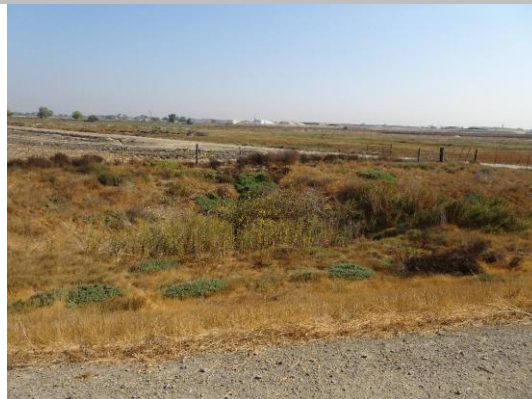
Photo 2 of 3 : UCIP_SP_2022_70645_90583.jpg

LS view: Pipe and headwall are not visible at LS toe from levee crown

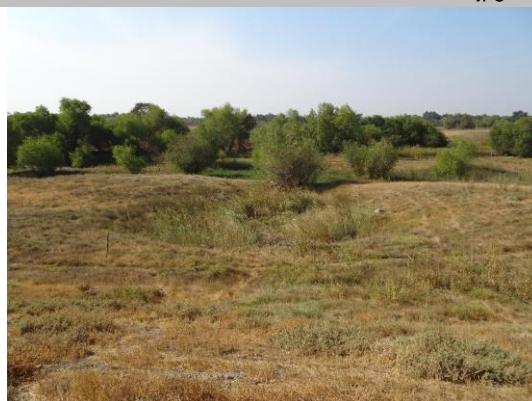
Photo 3 of 3 : UCIP_SP_2022_70645_90582.jpg

WS view: Pipe, flapgate, and headwall are not visible at WS toe from levee crown

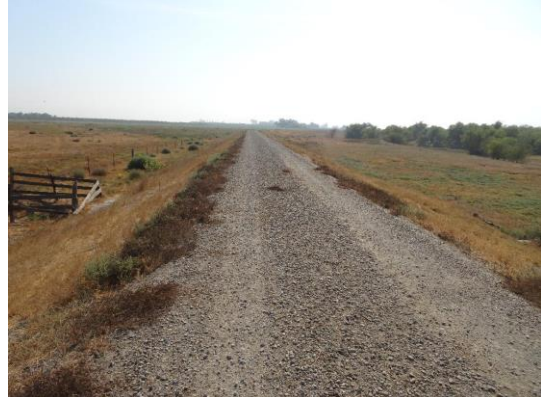
Photo 1 of 3 : UCIP_SP_2022_70646_90611.jpg

Comment Code						
Inspector Comment						
FS_ID:70646 DS_ID:19591 EP_NO: N/A Repair Type: Non-Urgent Crossing Status: Found UCIP Comments: 10/06/2020 Record remains Non-Urgent. Rodent activity found in the general area. No permit was found authorizing this encroachment. CVFPB will need to review crossing to determine owner. DWR DMP has not found internal issues, LOF between 1 and 2. Recommend inspection in 5 years. (B. Singh - GEI, O. Magana - DWR UCIP)04/08/2014 Need to contact owner to determine crossing status. Inlet drop box silted in and needs to be cleaned out. (W. Wylie - DWR UCIP) FIELD_STRUCT_DESC: 24-inch corrugated metal (CM) gravity drainage pipe through the levee, 9.7 feet below the crown. Flap gate on the waterside (WS) end. Brass cap No. 100 bench mark (BM) on the headwall on the landside (LS). Wooden barrier around drop inlet on the LS toe. [Additional Reference(s): DWR Levee Log, 2002, (HLM 1.98). USACE San Joaquin O&M Manual, Unit No. 601, Part No. 1, (SJR601.1), 1967, Revised 25 May 2011, (HLM 1.98)]. FS Date: 10/6/2020

Overview of levee crown, looking US

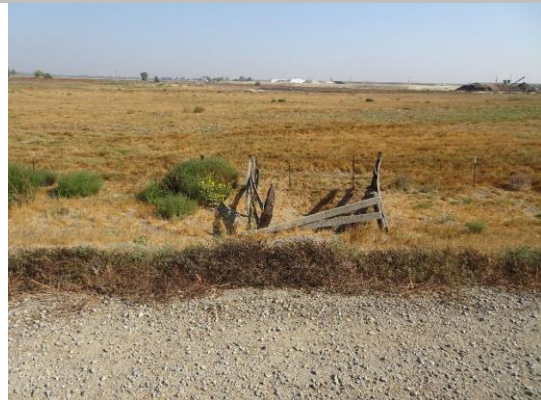
Photo 2 of 3 : UCIP_SP_2022_70646_90613.jpg

LS view: View toward LS pipe and headwall from levee crown

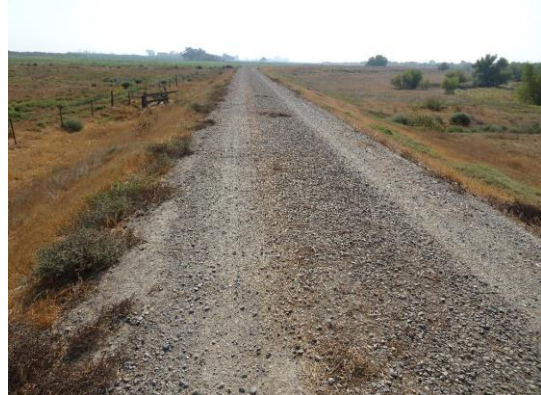
Photo 1 of 3 : UCIP_SP_2022_70647_90617.jpg

Comment Code					
Inspector Comment					
FS_ID:70647 DS_ID:19570 EP_NO: N/A Repair Type: Urgent Crossing Status: Found UCIP Comments: 10/06/2020 Record updated from Non-Urgent to Urgent. DMP internal video inspection has found pipe integrity issues. LOF of crossing is between 5 and 6. Crossing will be monitored until funding becomes available to address the issues. Wooden barrier surrounding drop-inlet is dilapidated. No permit was found authorizing this encroachment. CVFPB will need to review crossing to determine owner. (B. Singh - GEI, O. Magana - DWR UCIP) 04/08/2014 Unable to find inlet on landward toe. Recommend clearing vegetation on landward side to properly inspect inlet. (W. Wylie - DWR UCIP) FIELD_STRUCT_DESC: 24-inch corrugated metal (CM) gravity drainage pipe through the levee, 9.8 feet below the crown. Flap gate on the waterside (WS) end. Brass cap No. 100 bench mark (BM) on the headwall on the landside (LS). [Additional Reference(s): DWR Levee Log, 2002, (HLM 2.08). USACE San Joaquin O&M Manual, Unit No. 601, Part No. 1, (SJR601.1), 1967, Revised 25 May 2011, (HLM 2.08)]. FS Date: 10/6/2020

Overview of levee crown, looking US

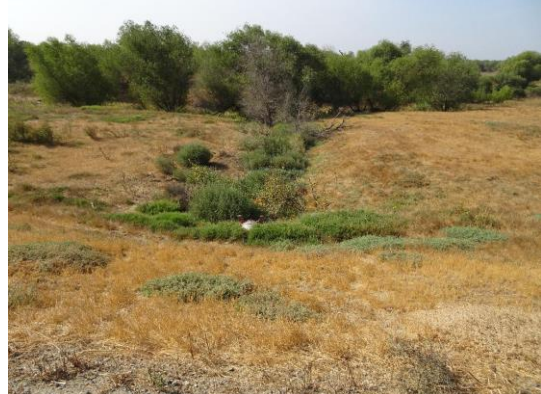
Photo 2 of 3 : UCIP_SP_2022_70647_90618.jpg

WS view: Pipe and flapgate visible on WS toe

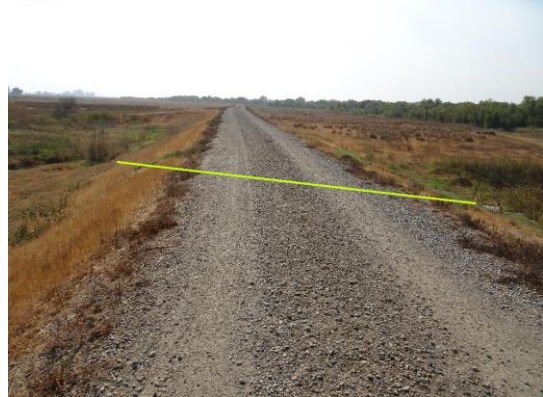
Photo 1 of 3 : UCIP_SP_2022_70648_90625.jpg

Comment Code						
Inspector Comment						
FS_ID:70648 DS_ID:19571 EP_NO: N/A Repair Type: Non-Urgent Crossing Status: Found UCIP Comments: 10/06/2020 Record has been updated from No Action Needed to Non-Urget. Pipe angle through the levee. System description has been updated. No permit was found authorizing this encroachment. CVFPB will need to review crossing to determine owner. DWR DMP internal inspection is pending and scheduled for 2021. (B. Singh - GEI, O. Magana - DWR UCIP) FIELD_STRUCT_DESC: 36-inch corrugated metal (CM) gravity drainage pipe through the levee at an angle, 12.6 feet below the crown. Flap gate on the waterside (WS) end. Brass cap No. 100 bench mark (BM) on the headwall on the landside (LS). Wooden barrier around drop inlet on the LS toe. [Additional Reference(s): DWR Levee Log, 2002, (HLM 2.25). USACE San Joaquin O&M Manual, Unit No. 601, Part No. 1, (SJR601.1), 1967, Revised 25 May 2011, (HLM 2.25)]. FS Date: 10/6/2020

Overview of levee crown, looking US. Pipe angled through levee at alignment shown

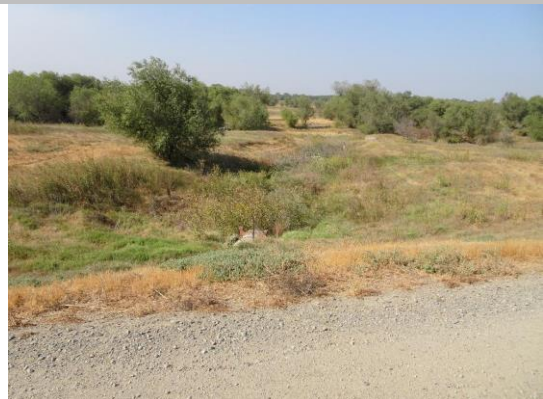
Photo 2 of 3 : UCIP_SP_2022_70648_90626.jpg

WS view: Pipe and flapgate visible on WS toe

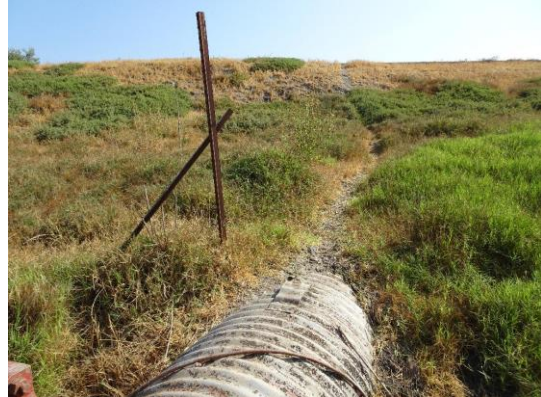
Photo 3 of 3 : UCIP_SP_2022_70648_90629.jpg

WS view: Pipe and slope on WS toe

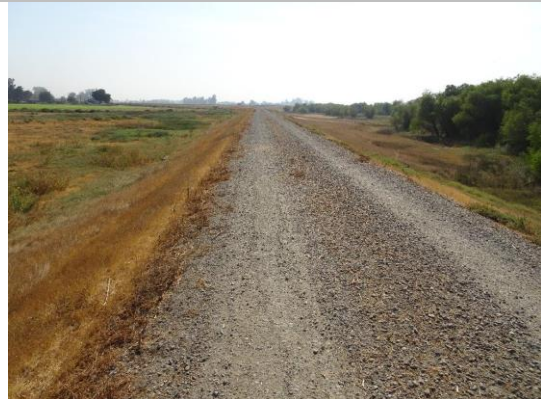
Photo 1 of 3 : UCIP_SP_2022_70649_90632.jpg

FS_ID:70649
DS_ID:19572
EP_NO: N/A
Repair Type: Non-Urgent
Crossing Status: Found
UCIP Comments: 10/06/2020 Record has been updated from No Action Needed to Non-Urgent. No permit was found authorizing this encroachment. CVFPB will need to review crossing to determine owner. DWR DMP has not found internal issues, LOF between 1 and 2. Recommend inspection in 5 years. (B. Singh - GEI, O. Magana - DWR UCIP)
FIELD_STRUCT_DESC: 24-inch corrugated metal (CM) gravity drainage pipe through the levee, 8.0 feet below the crown. Flap gate on the waterside (WS) end. Brass cap No. 100 bench mark (BM) on the headwall on the landside (LS). [Additional Reference(s): DWR Levee Log, 2002, (HLM 2.53). USACE San Joaquin O&M Manual, Unit No. 601, Part No. 1, (SJR601.1), 1967, Revised 25 May 2011, (HLM 2.52)].
FS Date: 10/6/2020

Overview of levee crown, looking US

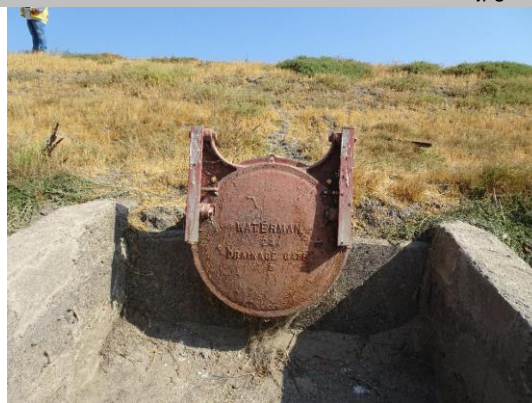
Photo 3 of 3 : UCIP_SP_2022_70649_90635.jpg

WS view: Pipe, flapgate, and headwall on WS toe

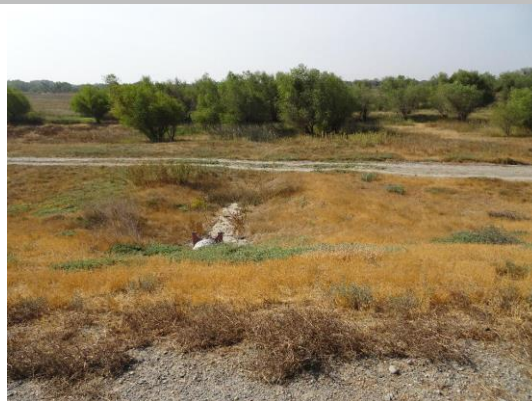
Photo 2 of 3 : UCIP_SP_2022_70650_90638.jpg

WS view: Pipe and flapgate visible on WS toe

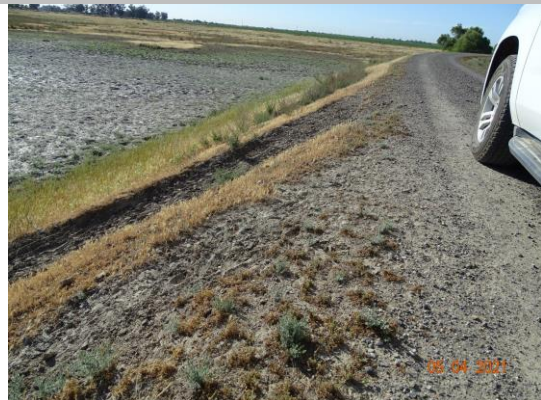
Photo 1 of 1 : SP_2022_NA0010_118_104_20220308_00009.jpg

LM Start	3.06	Rating **	M	Issue No.	104
LM End	3.06	Issue Type +	Ma	Location *	LS
Category	Earthen Levee			GPS Latitude/Longitude	
				Start	End
Item	Erosion / Livestock			37.322499 °	37.322499 °
				-120.928986 °	-120.928986 °
DWR ID	DWR_NA0010_01_f_2017_104				
Comment Code					
E4 : Repair the levee slope damaged by livestock and prevent large animal access.					
Inspector Comment					
Slope damage caused by animal foot traffic.

Slope damage on the landside slope from livestock traffic. (Spring 2021)

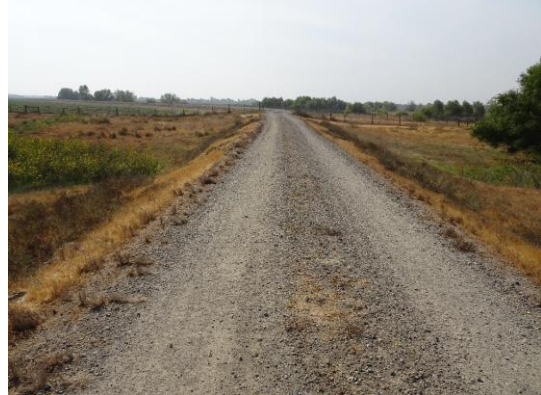
Photo 1 of 3 : UCIP_SP_2022_70651_90644.jpg

FS_ID:70651
DS_ID:19574
EP_NO: N/A
Repair Type: Non-Urgent
Crossing Status: Found
UCIP Comments: 10/06/2020 Record remains Non-Urgent. No permit was found authorizing this encroachment. CVFPB will need to review crossing to determine owner. DWR DMP internal inspection is pending and scheduled for 2021. (B. Singh - GEI, O. Magana - DWR UCIP)04/08/2014 Some minor erosion around headwall on LS toe. (W. Wylie - DWR UCIP)
FIELD_STRUCT_DESC: 36-inch corrugated metal (CM) gravity drainage pipe through the levee, 8.0 feet below the crown. Flap gate on the waterside (WS) end. Brass cap No. 100 bench mark (BM) on the headwall on the landside (LS). [Additional Reference(s): DWR Levee Log, 2002, (HLM 3.17). USACE San Joaquin O&M Manual, Unit No. 601, Part No. 1, (SJR601.1), 1967, Revised 25 May 2011, (HLM 3.16)].
FS Date: 10/6/2020

Overview of levee crown, looking US

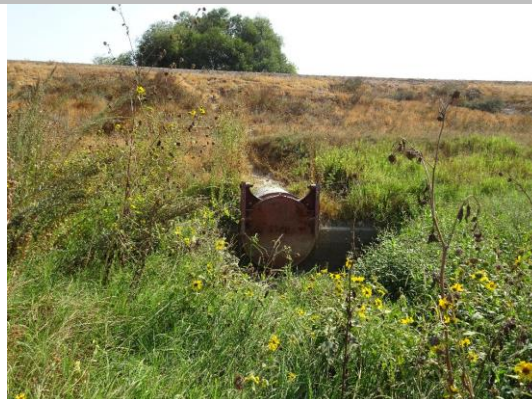
Photo 3 of 3 : UCIP_SP_2022_70651_90646.jpg

WS view: Pipe, flapgate, and headwall at WS toe

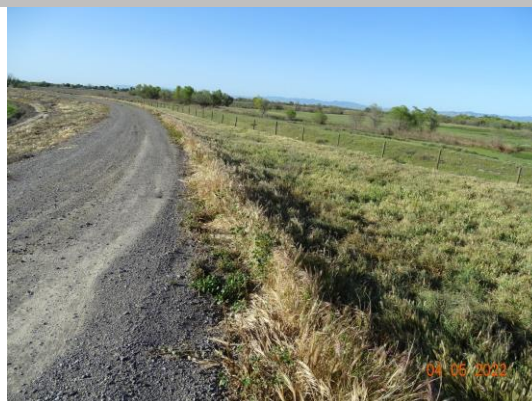
Photo 1 of 1 : SP_2022_NA0010_118_123_20220412_00299.jpg

LM Start	3.16	Rating **	M	Issue No.	123
LM End	3.35	Issue Type +	Ma	Location *	WS
Category	Earthen Levee			GPS Latitude/Longitude	
				Start	End
Item	Vegetation			37.321052 °	37.318644 °
				-120.928812 °	-120.927340 °
DWR ID	DWR_NA0010_01_s_2022_123				
Comment Code					
V1 : Control annual grass and weeds on the levee slopes and easements.					
Inspector Comment

View of the waterside slope looking upstream. (Spring 2022)

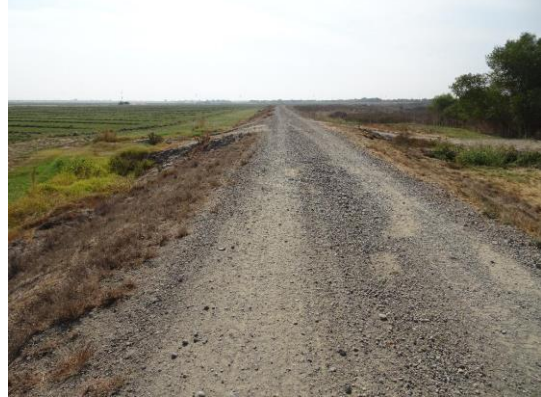
Photo 1 of 3 : UCIP_SP_2022_70652_90588.jpg

Comment Code						
Inspector Comment						
FS_ID:70652 DS_ID:19575 EP_NO: N/A Repair Type: Urgent Crossing Status: Found UCIP Comments: 10/06/2020 Record remains Urgent. Sinkhole present directly above the LS headwall and along pipe alignment. Pipe collapse visible from from the LS toe. Erosion present on the WS just behind the flap gate. No permit was found authorizing this encroachment. CVFPB will need to review crossing to determine owner. DWR DMP internal inspection is pending and scheduled in 2021. (B. Singh - GEI, O. Magana - DWR UCIP)11/01/2018 Pipe continues to rust through, causing the pipe to collapse on the LS. Sediment buildup visible from the LS inlet. Loss of soil just above the LS concrete headwall and along the LS slope. Crossing remains Urgent due to the levee slope issues and pipe failure through the levee. (O. Magana - DWR UCIP)07/19/2016 Same as previous inspection. Erosion present on LS slope. (O. Magana - DWR UCIP)04/08/2014 Pipe rusted through at Springline on LS toe. Flapgate blocked by sediment on WS toe. Heavy sediment on both ends of pipe. Need to contact owner to address issues. (W. Wylie - DWR UCIP) FIELD_STRUCT_DESC: 36-inch corrugated metal (CM) gravity drainage pipe through the levee, 9.7 feet below the crown. Flap gate on the waterside (WS) end. Brass cap No. 100 bench mark (BM) on the headwall on the landside (LS). [Additional Reference(s): DWR Levee Log, 2002, (HLM 3.50). USACE San Joaquin O&M Manual, Unit No. 601, Part No. 1, (SJR601.1), 1967, Revised 25 May 2011, (HLM 3.50)]. FS Date: 10/6/2020

Overview of levee crown, looking US

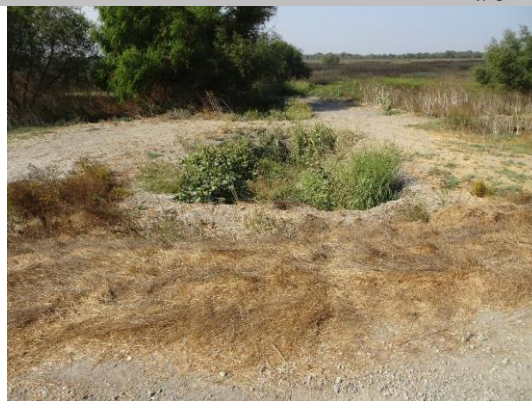
Photo 2 of 3 : UCIP_SP_2022_70652_90589.jpg

WS view: Pipe and flapgate not visible on WS toe due to vegetation

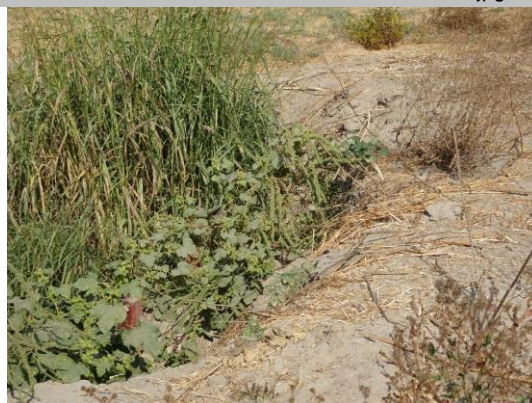
Photo 3 of 3 : UCIP_SP_2022_70652_92310.jpg

WS view: through the dense vegetation the pipe and red flap gate are visible.

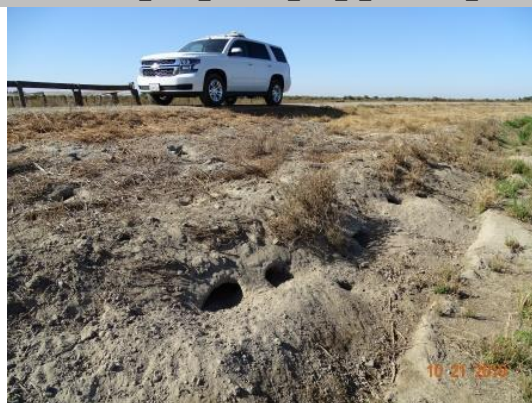
Photo 1 of 1 : SP_2022_NA0010_118_2_20220308_00001.jpg

LM Start	3.87	Rating **	U	Issue No.	2
LM End	3.90	Issue Type +	Ma	Location *	LS
Category	Earthen Levee			GPS Latitude/Longitude	
				Start	End
Item	Animal Control			37.311798 °	37.311341 °
				-120.927670 °	-120.927365 °
DWR ID	DWR_NA0010_01_s_2012_2				
Comment Code					
A1 : Exterminate rodents and backfill and compact or grout burrows.					
Inspector Comment					
Several rodent burrows are along this section of the levee.

View of rodent burrows in this section looking downstream. (Fall 2019)

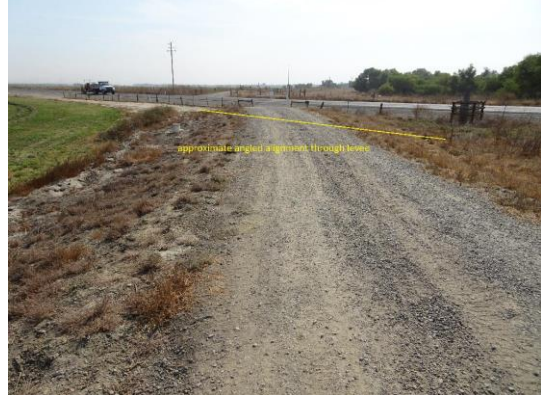
Photo 1 of 3 : UCIP_SP_2022_70653_90650.jpg

Comment Code					
Inspector Comment					
FS_ID:70653 DS_ID:19576 EP_NO: N/A Repair Type: Urgent Crossing Status: Found UCIP Comments: 10/06/2020 Record updated from Non-Urgent to Urgent. Heavy siltation through the length of the pipe was observed and recommend removal. Flap gate is missing on the WS toe. Recommend adding flap gate to prevent flooding from the WS to the LS. No permit was found authorizing this encroachment. CVFPB will need to review crossing to determine owner. DWR DMP internal inspection is pending and scheduled for 2021. Pipe goes through the levee at an angle. System description has been updated to include angled pipe information.(B. Singh - GEI, O. Magana - DWR UCIP)04/08/2014 Slide gate missing from WS. No closure device, but degrading of levee at Highway 140 is lower than pipe, so this does not appear to be a critical issue. Also dense vegetation limits the inspector's visibility to identify signs of pipe failure (leaks) along the slope. Recommend removing vegetation along pipe alignment to conduct proper inspection of structure and appurtenances. (W. Wylie - DWR UCIP) FIELD_STRUCT_DESC: 30-inch corrugated metal (CM) gravity drainage pipe through the levee at an angle, 3.5 feet below the crown. Flap gate on the waterside (WS) end. Brass cap No. 100 bench mark (BM) on the headwall on the landside (LS). [Additional Reference(s): DWR Levee Log, 2002, (HLM 3.95). USACE San Joaquin O&M Manual, Unit No. 601, Part No. 1, (SJR601.1), 1967, Revised 25 May 2011, (HLM 3.95)]. FS Date: 10/6/2020

Overview of levee crown, looking US. Angled pipe alignment through levee crown approximated.

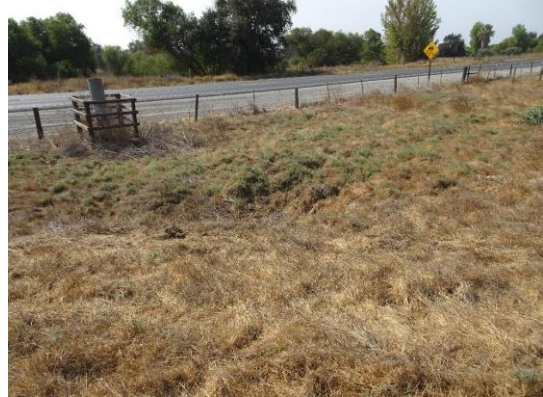
Photo 2 of 3 : UCIP_SP_2022_70653_90651.jpg

WS view: View toward WS toe. Pipe not visible.

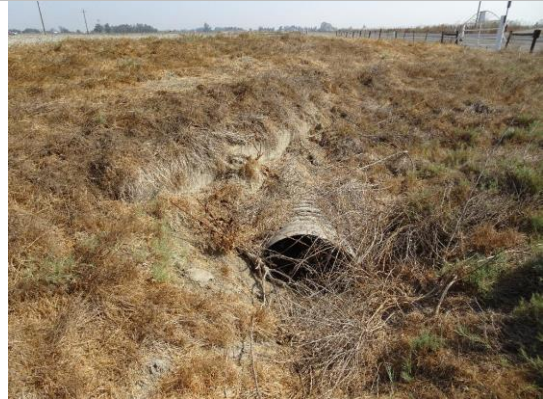
Photo 3 of 3 : UCIP_SP_2022_70653_90652.jpg

WS view: Heavy siltation at WS invert. Pipe flapgate missing at WS toe.

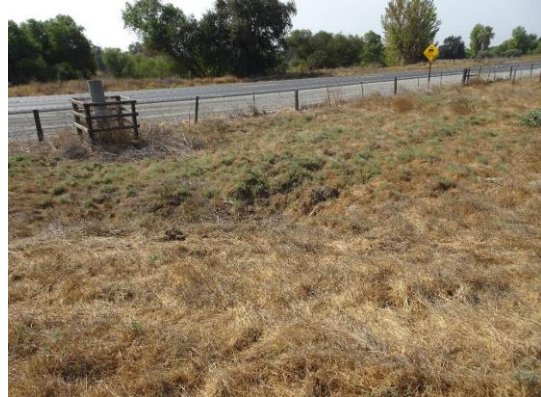
Photo 1 of 3 : UCIP_SP_2022_70654_90656.jpg

Comment Code						
Inspector Comment						
FS_ID:70654 DS_ID:19606 EP_NO: N/A Repair Type: Non-Urgent Crossing Status: Indicator Found UCIP Comments: 10/06/2020 Record remains Non-Urgent. No permit was found authorizing this encroachment. CVFPB will need to review crossing to determine owner. Unable to confirm alignment of pipe through the levee. Need to contact owner to determine status update on this pipe. (B. Singh - GEI, O. Magana - DWR UCIP)04/08/2014 Need to contact owner to determine status of crossing inlet and outlet not found. (W. Wylie - DWR UCIP) FIELD_STRUCT_DESC: 12-inch reinforced concrete (RC) irrigation discharge pipe through the levee, 3.5 feet below the crown. 12-inch concrete standpipe off each side of the levee. [Additional Reference(s): DWR Levee Log, 2002, (HLM 3.96)]. FS Date: 10/6/2020

Overview of 12-inch standpipe at WS toe

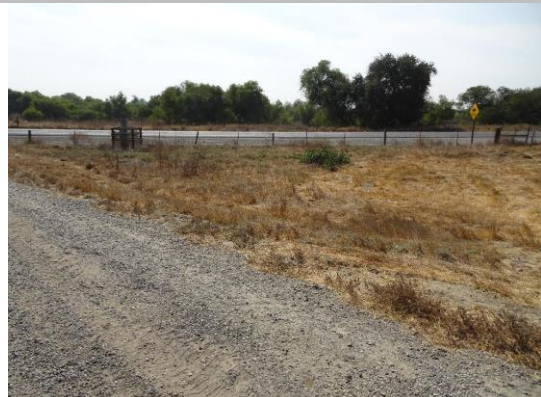
Photo 2 of 3 : UCIP_SP_2022_70654_90657.jpg

Overview of WS slope and levee crown, looking US.

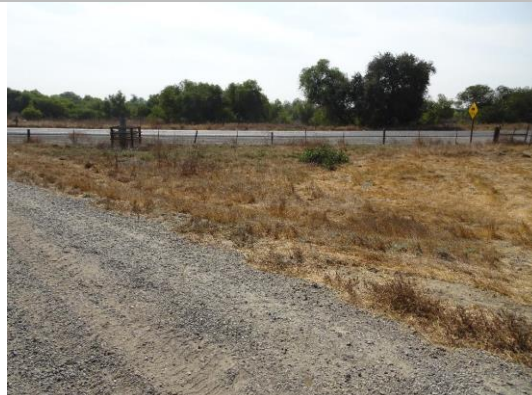
Photo 3 of 3 : UCIP_SP_2022_70654_92329.jpg

WS view: overview of WS slope looking towards crossings.

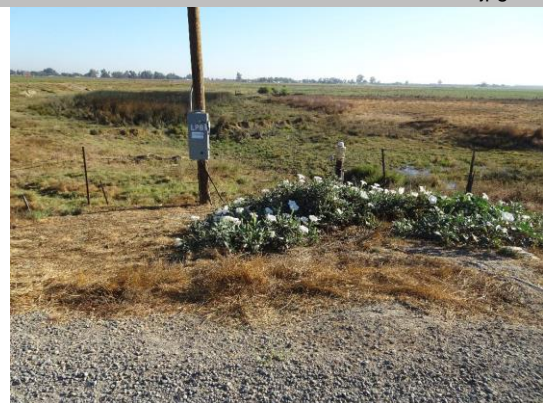
Photo 2 of 3 : UCIP_SP_2022_70655_90659.jpg

LS view: View toward LS toe from levee crown

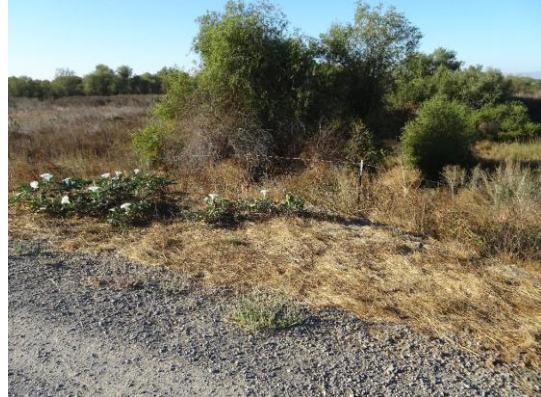
Photo 3 of 3 : UCIP_SP_2022_70655_90660.jpg

WS view: View toward WS toe from levee crown

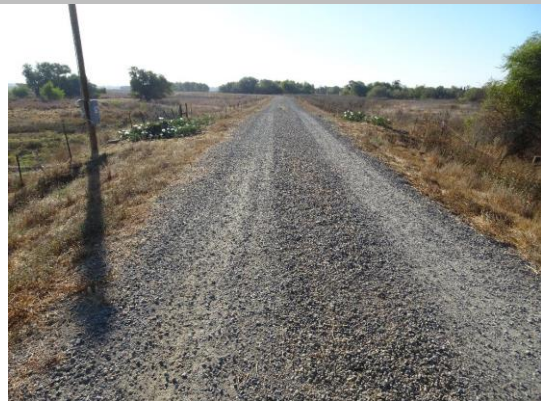
Photo 1 of 3 : UCIP_SP_2022_70656_92354.jpg

FS_ID:70656
DS_ID:24866
EP_NO: N/A
Repair Type: Non-Urgent
Crossing Status: Found
UCIP Comments: 10/20/2020 Record remains Non-Urgent. Barbed wire prevented access to the pipe located on the LS toe. Unpermitted modifications were made to the structure. There appears to be multiple crossings at this location, two 12-inch pipes and 48-inch refurbished pipe. Recommend contacting owner to determine status of structure and obtain as-builts. No permit was found authorizing these encroachments. CVFPB will need to review crossing to determine owner(s). (B. Singh - GEI, O. Magana - DWR UCIP)04/08/2014 Need to contact owner to get details of crossing. (W. Wylie - DWR UCIP)
FIELD_STRUCT_DESC: 12-inch steel drainage discharge pipe through the levee, 2.5 feet below the crown. 12-inch steel pipe, vent, and pump on stand visible on the landside (LS) slope. 10-inch polyvinyl chloride (PVC) pipe visible on the waterside (WS) slope.

Overview of levee crown looking upstream towards crossings.

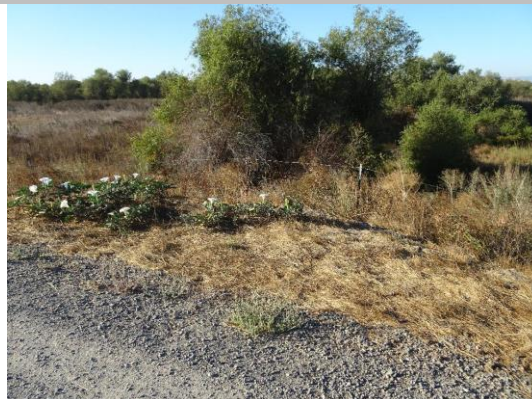
Photo 2 of 3 : UCIP_SP_2022_70656_92356.jpg

WS view: overview of WS

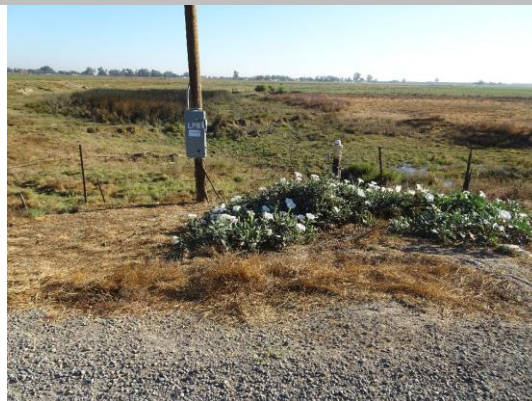
Photo 3 of 3 : UCIP_SP_2022_70656_92355.jpg

LS view: overview of LS

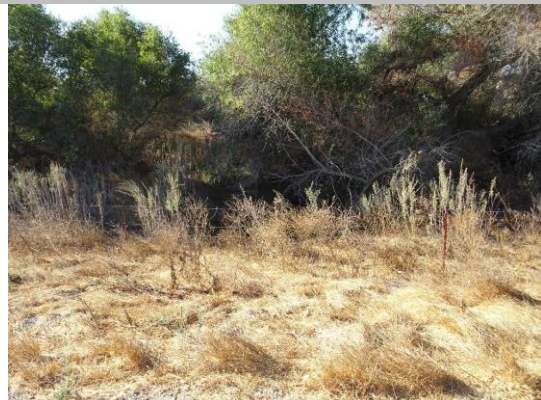
Photo 2 of 3 : UCIP_SP_2022_70657_90670.jpg

LS view: View toward LS toe from levee crown

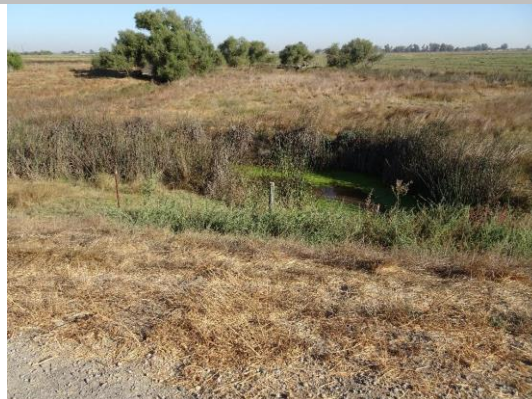
Photo 3 of 3 : UCIP_SP_2022_70657_90669.jpg

WS view: View toward WS toe from levee crown

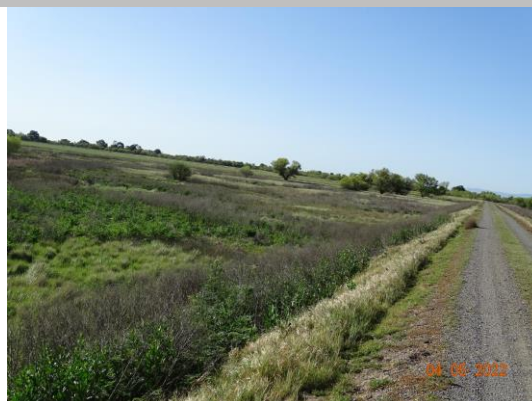
Photo 1 of 1 : SP_2022_NA0010_118_124_20220412_00300.jpg

LM Start	4.31	Rating **	M	Issue No.	124
LM End	4.78	Issue Type +	Ma	Location *	LS
Category	Earthen Levee			GPS Latitude/Longitude	
				Start	End
Item	Vegetation			37.307525 °	37.301192 °
				-120.921965 °	-120.920599 °
DWR ID	DWR_NA0010_01_s_2022_124				
Comment Code					
V1 : Control annual grass and weeds on the levee slopes and easements.					
Inspector Comment

View of vegetation growing on the landside slope. (Spring 2022)

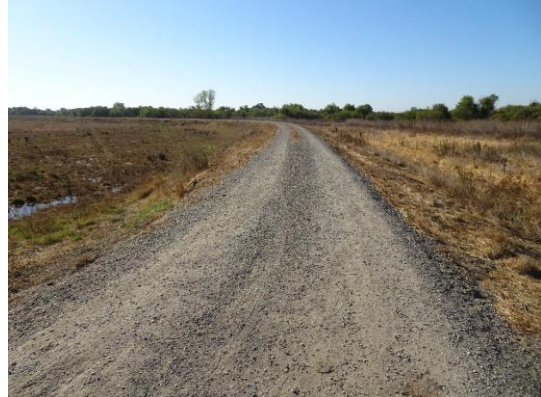
Photo 1 of 3 : UCIP_SP_2022_70658_90676.jpg

Comment Code						
Inspector Comment						
FS_ID:70658 DS_ID:19609 EP_NO: N/A Repair Type: Urgent Crossing Status: Found UCIP Comments: 10/20/2020 Record has been updated from Non-Urgent to Urgent. DWR DMP has found integrity issues, LOF, between 5 and 6. Crossing will be monitored until funding becomes available to address. Evidence of the landslide visible on the LS slope from the levee crown. No permit was found authorizing this encroachment. CVFPB will need to review crossing to determine owner. (B. Singh - GEI, O. Magana - DWR UCIP)04/08/2014 Dense vegetation limits the inspector's visibility to identify signs of pipe failure (leaks) along the waterward side. Recommend removing vegetation along pipe alignment to conduct proper inspection of structure and appurtenances. (W. Wylie - DWR UCIP) FIELD_STRUCT_DESC: 24-inch corrugated metal (CM) gravity drainage pipe through the levee, 10.0 feet below the crown. Flap gate on the waterside (WS) end. Brass cap No. 90 bench mark (BM) on the headwall on the landside (LS). [Additional Reference(s): DWR Levee Log, 2002, (HLM 4.73). USACE San Joaquin O&M Manual, Unit No. 601, Part No. 1, (SJR601.1), 1967, Revised 25 May 2011, (HLM 4.72)]. FS Date: 10/20/2020

Overview of levee crown, looking US

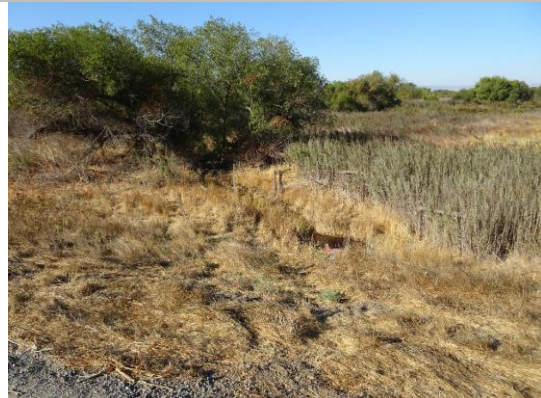
Photo 2 of 3 : UCIP_SP_2022_70658_90678.jpg

WS view: Pipe and flapgate visible at WS toe

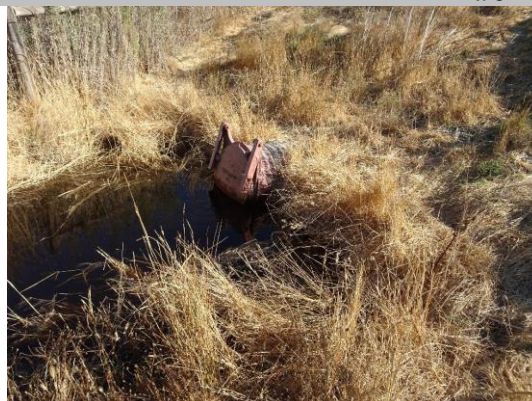
Photo 3 of 3 : UCIP_SP_2022_70658_90679.jpg

WS view: Pipe and flapgate at WS toe

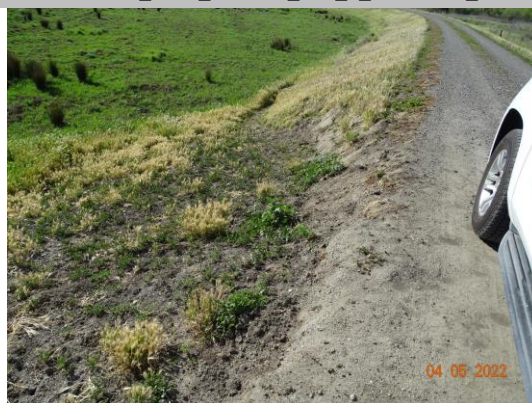
Photo 1 of 1 : SP_2022_NA0010_118_9_20220412_00301.jpg

LM Start	4.69	Rating **	M	Issue No.	9
LM End	4.69	Issue Type +	Ma	Location *	LS
Category	Earthen Levee			GPS Latitude/Longitude	
				Start	End
Item	Erosion / Livestock			37.302398 °	37.302398 °
				-120.920920 °	-120.920920 °
DWR ID	DWR_NA0010_01_s_2013_9				
Comment Code					
E4 : Repair the levee slope damaged by livestock and prevent large animal access.					
Inspector Comment					
Material used to repair the livestock damage in 2021 has eroded away.

View of damage to the landside slope from livestock. (Spring 2022)

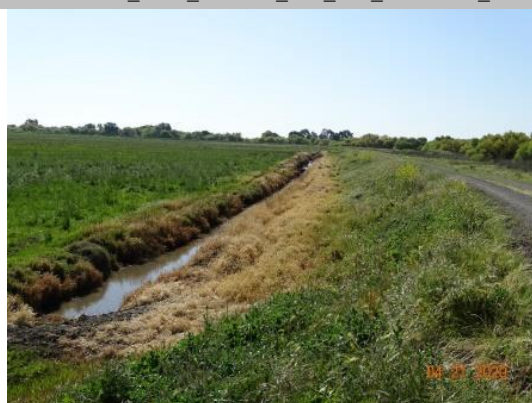
Photo 1 of 1 : SP_2022_NA0010_118_107_20220308_00011.jpg

LM Start	4.77	Rating **	M	Issue No.	107
LM End	5.32	Issue Type +	En	Location *	LS
Category	Earthen Levee			GPS Latitude/Longitude	
				Start	End
Item	Encroachments			37.301269 °	37.300396 °
				-120.920660 °	-120.912625 °
DWR ID	DWR_NA0010_01_s_2019_107				
Comment Code					
DT : Ditch					
Inspector Comment					
Ditch it roughly 8-15 ft away from levee toe.

Looking upstream at an irrigation ditch along the landside toe. (Spring 2020)

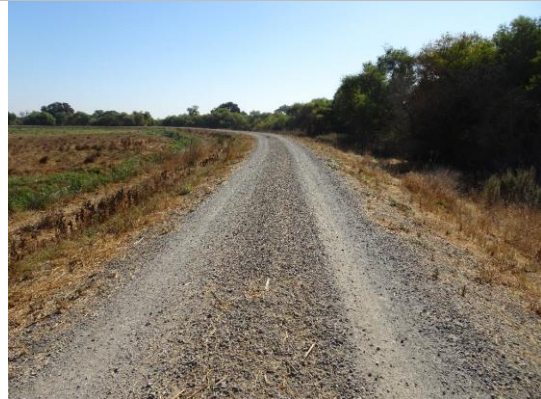
Photo 1 of 3 : UCIP_SP_2022_70659_90682.jpg

Comment Code						
Inspector Comment						
FS_ID:70659 DS_ID:19610 EP_NO: N/A Repair Type: Non-Urgent Crossing Status: Found UCIP Comments: 10/20/2020 Record remains Non-Urgent. Unable to locate inlet on the LS toe. Ditch runs along the LS toe. Ditch was running full and no signs of pipe inlet were visible. This pipe appears to be non-functional--only WS pipe outlet found. No permit was found authorizing this encroachment. CVFPB will need to review crossing to determine owner. DWR DMP internal inspection is pending and scheduled for 2021. (B. Singh - GEI, O. Magana - DWR UCIP)04/08/2014 Non-functional -- sediment buildup against flapgate and inlet buried at landward side. (W. Wylie - DWR UCIP) FIELD_STRUCT_DESC: 24-inch corrugated metal (CM) gravity drainage pipe through the levee, 8.0 feet below the crown. Flap gate on the waterside (WS) end. Brass cap No. 90 bench mark (BM) on the headwall on the landside (LS). Drainage ditch along the LS toe. [Additional Reference(s): DWR Levee Log, 2002, (HLM 5.06). USACE San Joaquin O&M Manual, Unit No. 601, Part No. 1, (SJR601.1), 1967, Revised 25 May 2011, (HLM 5.05)]. FS Date: 10/20/2020

Overview of levee crown, looking US

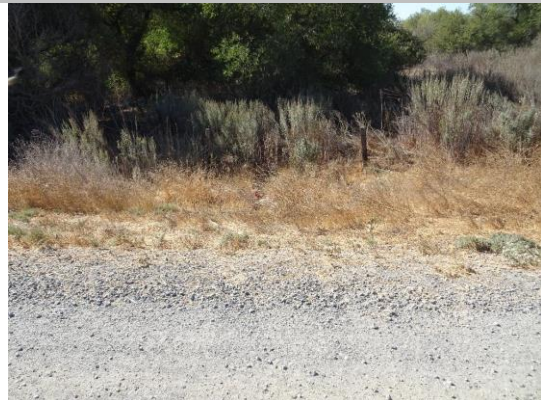
Photo 2 of 3 : UCIP_SP_2022_70659_90684.jpg

WS view: Pipe and flapgate visible on WS toe

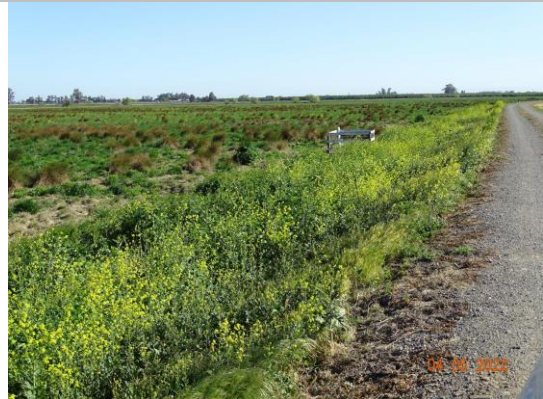
Photo 1 of 1 : SP_2022_NA0010_118_125_20220412_00302.jpg

LM Start	5.43	Rating **	M	Issue No.	125
LM End	6.53	Issue Type +	Ma	Location *	LS
Category	Earthen Levee			GPS Latitude/Longitude	
				Start	End
Item	Vegetation			37.301512 °	37.304059 °
				-120.911230 °	-120.893346 °
DWR ID	DWR_NA0010_01_s_2022_125				
Comment Code					
V1 : Control annual grass and weeds on the levee slopes and easements.					
Inspector Comment

Looking upstream along the landside slope. (Spring 2022)
