**Flood Control Project Maintenance
Levee Inspections
LMA District Cover Sheet**

Lower San Joaquin Levee District

**Flood Control Project Maintenance
Levee Inspections
Unit Cover Sheet**

Levee Inspection Report By Mile - Spring 2022

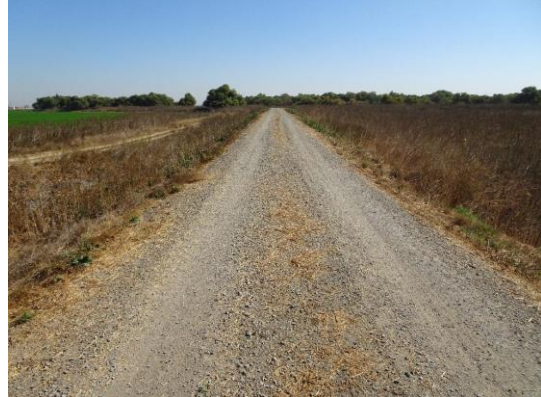
Photo 1 of 3 : UCIP_SP_2022_70660_90689.jpg

Comment Code						
Inspector Comment						
FS_ID:70660 DS_ID:19611 EP_NO: N/A Repair Type: Non-Urgent Crossing Status: Found UCIP Comments: 10/20/2020 Record remains Non-Urgent. Depression observed across levee crown, less than 6 inches in depth. Pipe inlet located at the LS toe is completely blocked by soil. This crossing is non-functional. Recommend evaluating the purpose of this drainage structure. No permit was found authorizing this encroachment. CVFPB will need to review crossing to determine owner. DWR DMP internal inspection is pending and scheduled for 2021. Recommend reviewing DMP's internal inspection when completed to investigate reason for depression across the levee crown. (B. Singh - GEI, O. Magana - DWR UCIP)04/08/2014 Dense vegetation limits the inspector's visibility to identify signs of pipe failure (leaks) along waterward and landward slopes. Recommend removing vegetation along pipe alignment to conduct proper inspection of structure and appurtenances. Landward side filled in with soil. Need to contact owner. If crossing is no longer used need to coordinate with CVFPB for proper abandonment. (W. Wylie - DWR UCIP) FIELD_STRUCT_DESC: 24-inch corrugated metal (CM) gravity drainage pipe through the levee, 8.6 feet below the crown. Flap gate on the waterside (WS) end. Brass cap No. 90 bench mark (BM) on the headwall on the landside (LS). [Additional Reference(s): DWR Levee Log, 2002, (HLM 5.96). USACE San Joaquin O&M Manual, Unit No. 601, Part No. 1, (SJR601.1), 1967, Revised 25 May 2011, (HLM 5.95)]. FS Date: 10/20/2020

Overview of levee crown, looking US

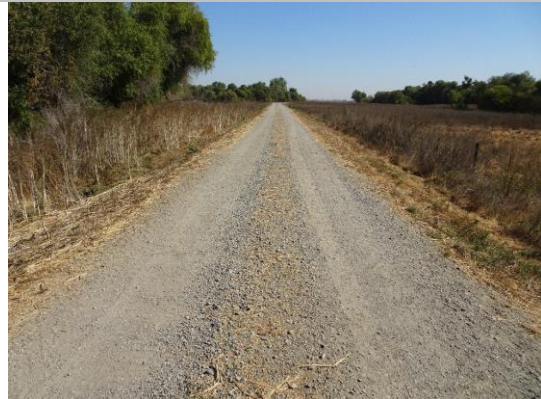
Photo 1 of 3 : UCIP_SP_2022_70661_90696.jpg

Comment Code						
Inspector Comment						
FS_ID:70661 DS_ID:19612 EP_NO: N/A Repair Type: Non-Urgent Crossing Status: Found UCIP Comments: 10/20/2020 Record remains Non-Urgent. Scour is still present on both sides of the concrete LS headwall. Dense vegetation prevented updates on the scour progression along the LS slope. Recommend re-inspecting pipe when vegetation is removed. Unable to access to WS outlet due to wired fence. No permit was found authorizing this encroachment. CVFPB will need to review crossing to determine owner. DWR DMP internal inspection is pending and scheduled for 2021. (B. Singh - GEI, O. Magana - DWR UCIP)04/08/2014 Dense vegetation limits the inspector's visibility to identify signs of pipe failure (leaks) along waterward and landward slopes. Recommend removing vegetation along pipe alignment to conduct proper inspection of structure and appurtenances. Pipe completely blocked by soil on LS toe due to animal activity. Slide gate blocked open. (W. Wylie - DWR UCIP) FIELD_STRUCT_DESC: 48-inch corrugated metal (CM) gravity drainage pipe through the levee at an angle, 13.1 feet below the crown. Walkway to slide gate at the concrete headwall on the landside (LS) toe. Flap gate at the concrete headwall on the waterside (WS) toe. Brass cap No. 90 bench mark (BM) on the headwall on the LS. [Additional Reference(s): DWR Levee Log, 2002, (HLM 6.13). USACE San Joaquin O&M Manual, Unit No. 601, Part No. 1, (SJR601.1), 1967, Revised 25 May 2011, (HLM 6.13)]. FS Date: 10/20/2020

Overview of levee crown, looking US

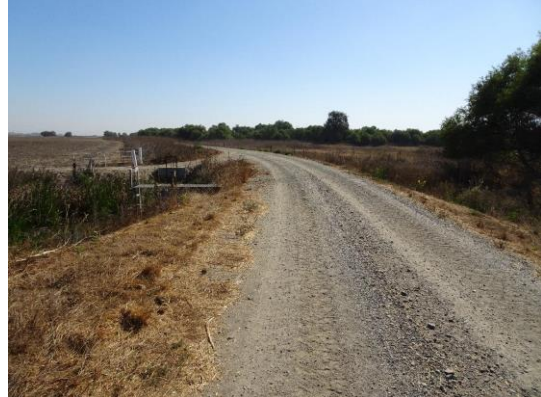
Photo 1 of 3 : UCIP_SP_2022_70662_90702.jpg

Comment Code						
Inspector Comment						
FS_ID:70662 DS_ID:19613 EP_NO: N/A Repair Type: Non-Urgent Crossing Status: Found UCIP Comments: 10/20/2020 Record remains Non-Urgent. Dense vegetation on WS toe, recommend removal for proper inspection. Minor surface erosion visible on the LS toe near the standpipe. No permit was found authorizing this encroachment. CVFPB will need to review crossing to determine owner. DWR DMP internal inspection is pending and scheduled for 2021. (B. Singh - GEI, O. Magana - DWR UCIP)04/08/2014 Dense vegetation limits the inspector's visibility to identify signs of pipe failure (leaks) along the slope. Recommend removing vegetation along pipe alignment to conduct proper inspection of structure and appurtenances. (W. Wylie - DWR UCIP) FIELD_STRUCT_DESC: 24-inch corrugated metal (CM) gravity drainage pipe through the levee, 9.5 feet below the crown. Flap gate on the waterside (WS) end. Slide gate on the landside (LS) end next to a 48-inch concrete riser unit with walkway over the top. Brass cap No. 90 bench mark (BM) on the headwall on the LS. [Additional Reference(s): DWR Levee Log, 2002, (HLM 6.44). USACE San Joaquin O&M Manual, Unit No. 601, Part No. 1, (SJR601.1), 1967, Revised 25 May 2011, (HLM 6.40)]. FS Date: 10/20/2020

Overview of levee crown, looking upstream

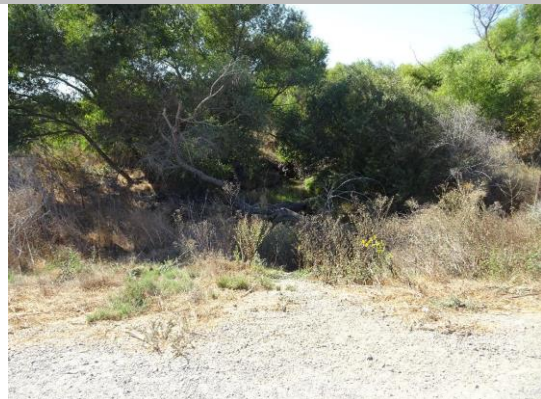
Photo 2 of 3 : UCIP_SP_2022_70662_90705.jpg

WS view: Headwall not visible on WS toe due to dense vegetation

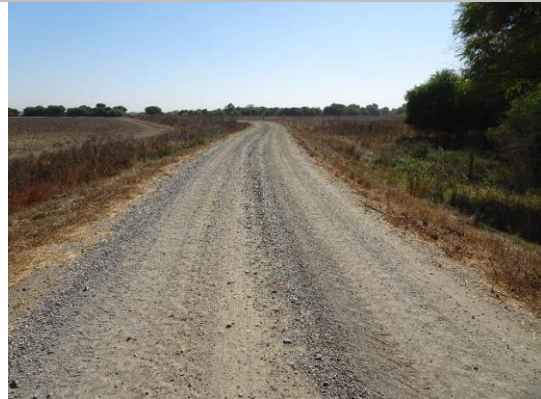
Photo 1 of 3 : UCIP_SP_2022_70663_90712.jpg

FS_ID:70663
DS_ID:19614
EP_NO: N/A
Repair Type: Non-Urgent
Crossing Status: Found
UCIP Comments: 10/20/2020 Record remains Non-Urgent. Dense vegetation inhibits inspection of the pipe on the LS toe, and both slopes. No permit was found authorizing this encroachment. CVFPB will need to review crossing to determine owner. DWR DMP internal inspection is pending and scheduled for 2021. (B. Singh - GEI, O. Magana - DWR UCIP)7/19/2016 Same as previous inspection. Outlet and inlet are under water. (O. Magana - DWR UCIP)4/08/2014 Flapgate blocked by sedimentation at WS toe. Dense vegetation limits the inspector's visibility to identify signs of pipe failure (leaks) along the slope. Recommend removing vegetation along pipe alignment to conduct proper inspection of structure and appurtenances. Also recommend clearing vegetation from both waterward and landward toe. (W. Wylie - DWR UCIP)
FIELD_STRUCT_DESC: 24-inch corrugated metal (CM) gravity drainage pipe through the levee, 9.8 feet below the crown. Wooden fence around a 4-foot by 4-foot drop inlet on the landside (LS) toe. Flap gate on the waterside (WS) end. Brass cap No. 90 bench mark (BM) on the headwall on the LS. [Additional Reference(s): DWR Levee Log, 2002, (HLM 6.65). USACE San Joaquin O&M Manual, Unit No. 601, Part No. 1, (SJR601.1), 1967, Revised 25 May 2011, (HLM 6.64)].

Overview of levee crown, looking US

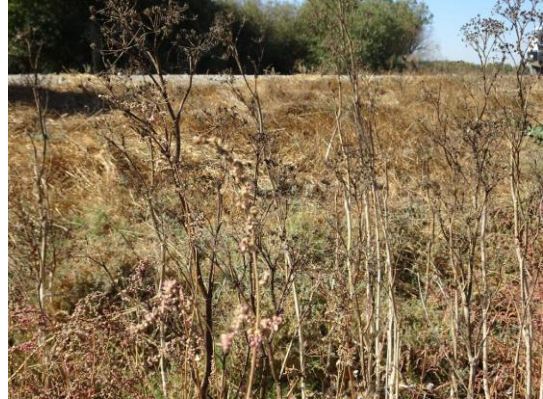
Photo 3 of 3 : UCIP_SP_2022_70663_90707.jpg

LS view: LS slope from LS toe

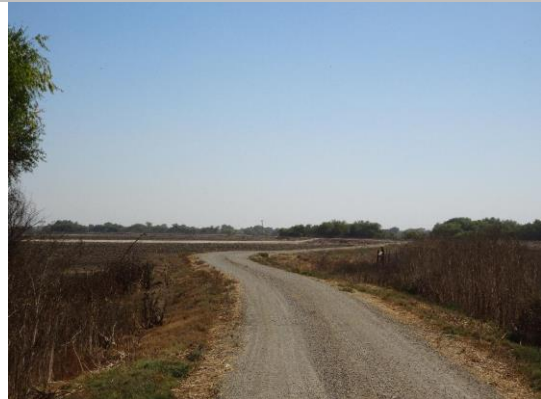
Photo 1 of 3 : UCIP_SP_2022_70664_90726.jpg

Comment Code						
Inspector Comment						
FS_ID:70664 DS_ID:19615 EP_NO: N/A Repair Type: Urgent Crossing Status: Found UCIP Comments: 10/20/2020 Record has been updated from Non-Urgent to Urgent. Heavy corrosion present with visible holes found at the WS outlet near flap gate. Surface erosion present on the LS slope just upstream of slide gate. Evidence of surface erosion on the WS slope (vertical slope) was present approximately 15 feet downstream of the pipe. Plastic sheeting has been placed to prevent further erosion by LMA (assumed). Recommend notifying DWR Levee Inspector to monitor progress of surface erosion on the WS. No permit was found authorizing this encroachment. CVFPB will need to review crossing to determine owner. DWR DMP internal inspection is pending and scheduled for 2021. (B. Singh - GEI, O. Magana - DWR UCIP)07/19/2016 Potential LS slope damage--difficult to determine due to dense vegetation. Limited access on WS toe due to wire fence. (O. Magana - DWR UCIP)04/08/2014 Slide gate blocked by debris at LS toe. Flapgate won't close because of debris. Dense vegetation limits the inspector's visibility to identify signs of pipe failure (leaks) along the slope. Recommend removing vegetation along pipe alignment to conduct proper inspection of structure and appurtenances. (W. Wylie - DWR UCIP) FIELD_STRUCT_DESC: 36-inch corrugated metal (CM) gravity drainage pipe through the levee, 10.3 feet below the crown. Slide gate on the landside (LS) toe. Flap gate on the waterside (WS) end. Brass cap No. 90 bench mark (BM) on the headwall on the LS. [Additional Reference(s): DWR Levee Log, 2002, (HLM 6.90). USACE San Joaquin O&M Manual, Unit No. 601, Part No. 1, (SJR601.1), 1967, Revised 25 May 2011, (HLM 6.90)]. FS Date: 10/20/2020

Overview of levee crown, looking US

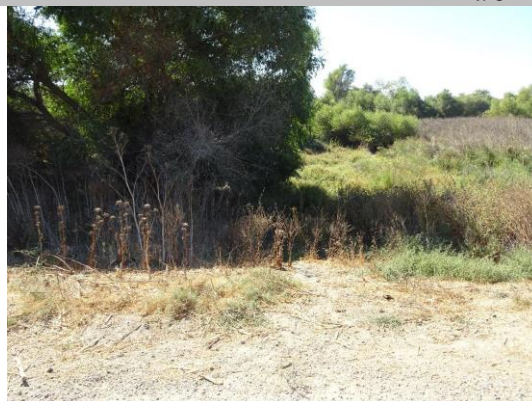
Photo 2 of 3 : UCIP_SP_2022_70664_92389.jpg

WS view: overview of WS.

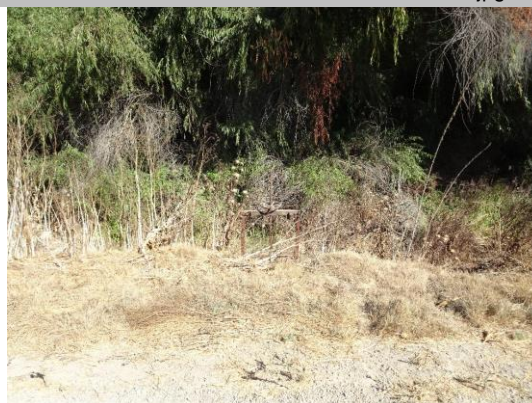
Photo 3 of 3 : UCIP_SP_2022_70664_90727.jpg

LS view: Pipe slidegate visible at LS toe.

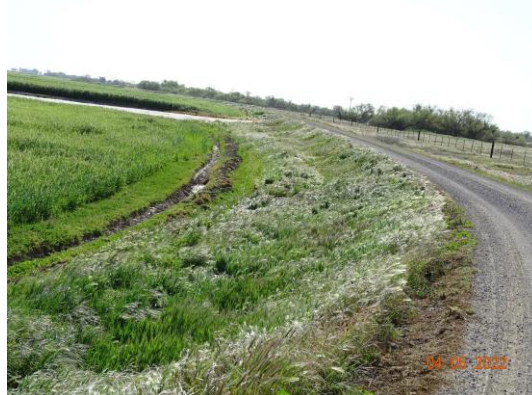
Photo 1 of 1 : SP_2022_NA0010_118_127_20220412_00303.jpg

LM Start	6.91	Rating **	M	Issue No.	127
LM End	8.67	Issue Type +	Ma	Location *	LS
Category	Earthen Levee			GPS Latitude/Longitude	
				Start	End
Item	Vegetation			37.301779 °	37.296873 °
				-120.887140 °	-120.856985 °
DWR ID	DWR_NA0010_01_s_2022_127				
Comment Code					
V1 : Control annual grass and weeds on the levee slopes and easements.					
Inspector Comment

View of vegetation growing on the landside slope. (Spring 2022)

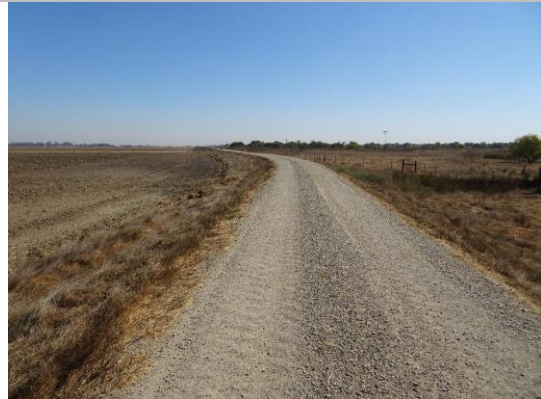
Photo 1 of 3 : UCIP_SP_2022_70665_90715.jpg

Comment Code						
Inspector Comment						
FS_ID:70665 DS_ID:19616 EP_NO: N/A Repair Type: Urgent Crossing Status: Found UCIP Comments: 10/20/2020 Record remains Urgent. DWR DMP has found integrity issues, LOF between 5 and 6. Pipe deeply corroded. No permit was found authorizing this encroachment. CVFPB will need to review crossing to determine owner. (B. Singh - GEI, O. Magana - DWR UCIP)11/01/2018 Pipe continues to corrode through. Voids (undermining) along pipe invert are visible from the LS. Potential undermining caused by erosion under concrete apron on the WS. Crossing remains Urgent due to the pipe failure. (O. Magana - DWR UCIP)04/08/2014 Pipe failing and corroded through at LS toe. Need to contact owner to determine status of crossing. Also dense vegetation limits the inspector's visibility to identify signs of pipe failure (leaks) along the landward slope. Recommend removing vegetation along pipe alignment to conduct proper inspection of structure. (W. Wylie - DWR UCIP) FIELD_STRUCT_DESC: 24-inch corrugated metal (CM) gravity drainage pipe through the levee, 5.1 feet below the crown. Flap gate on the waterside (WS) end. Brass cap No. 90 bench mark (BM) on the headwall on the landside (LS). [Additional Reference(s): DWR Levee Log, 2002, (HLM 7.22). USACE San Joaquin O&M Manual, Unit No. 601, Part No. 1, (SJR601.1), 1967, Revised 25 May 2011, (HLM 7.21)]. FS Date: 10/20/2020

Overview of levee crown, looking US

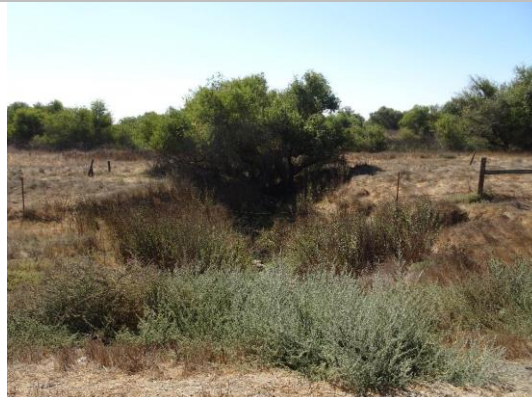
Photo 2 of 3 : UCIP_SP_2022_70665_90717.jpg

WS view: Pipe and flapgate at WS toe not visible from levee crown due to vegetation.

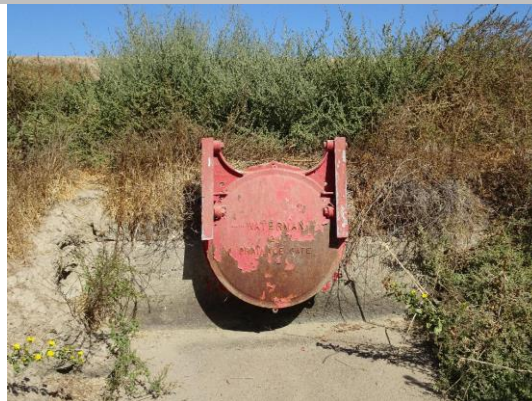
Photo 3 of 3 : UCIP_SP_2022_70665_90721.jpg

WS view: Pipe, flapgate, and headwall at WS toe.

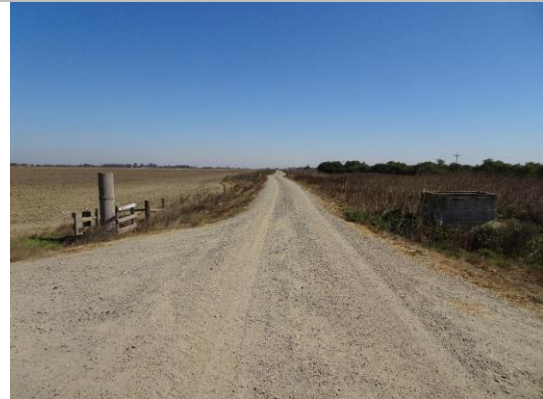
Photo 1 of 3 : UCIP_SP_2022_70666_90731.jpg

Comment Code						
Inspector Comment						
FS_ID:70666 DS_ID:19617 EP_NO: 4425 Repair Type: Non-Urgent Crossing Status: Found UCIP Comments: 10/20/2020 Record remains Non-Urgent. Additional structures (standpipes) located about 700 feet from levee crown. Due to safety concerns (lone worker), unable to access additional appurtenances located about 700 feet out from WS toe. Recommend having next UCIP inspector take close up photos of the structure located on the WS (riverbank). Recommend contacting owner to determine alignment of pipe through the levee and current status of pipe. The close-up photo of the structures near the riverbank show multiple concrete risers and control panel connected to power. Need to confirm current status of pipe. (B. Singh - GEI, O. Magana - DWR UCIP)04/08/2014 Recommend contacting owner to determine status of crossing. No pump was found on waterward side (riverbank). If crossing is no longer used need to coordinate with CVFPB for proper abandonment. (W. Wylie - DWR UCIP) FIELD_STRUCT_DESC: 24-inch concrete encased steel irrigation discharge pipe through the levee, 13.6 feet below the crown. Pipe encased in 6 inches of concrete through the levee. 5-foot by 7-foot concrete distribution box on the waterside (WS). 20-inch concrete standpipe at the landside (LS) toe. Pump on the riverbank accessible by walkway platform. Concrete cutoff walls around the pipe under each shoulder. Pipe extends to 36-inch concrete pipes on both sides of the levee. (Irrigation pipeline authorized under Permit No. 4425, 1964 - James J. Stevinson, a Corporation). [Additional Reference(s): DWR Levee Log, 2002, (HLM 7.33)]. FS Date: 10/20/2020

Overview of levee, looking US

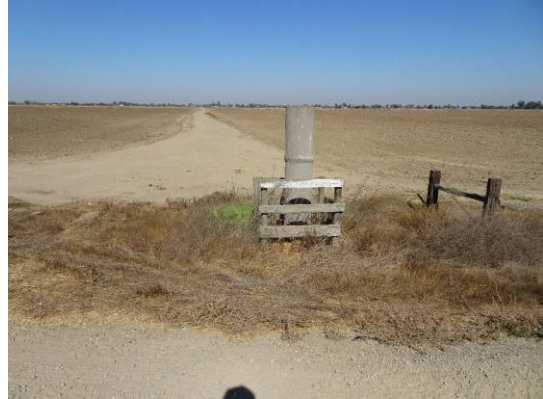
Photo 2 of 3 : UCIP_SP_2022_70666_90732.jpg

LS view: Concrete standpipe near LS toe

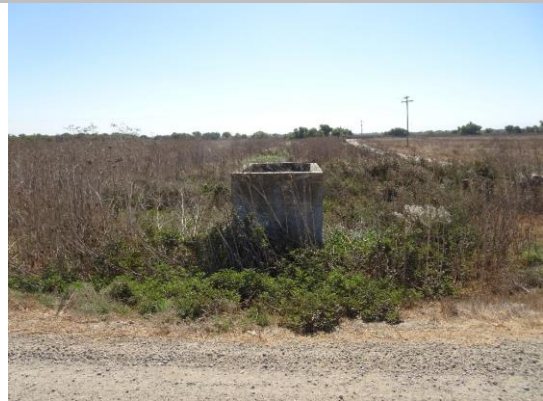
Photo 3 of 3 : UCIP_SP_2022_70666_90733.jpg

WS view: Concrete box riser at WS toe.

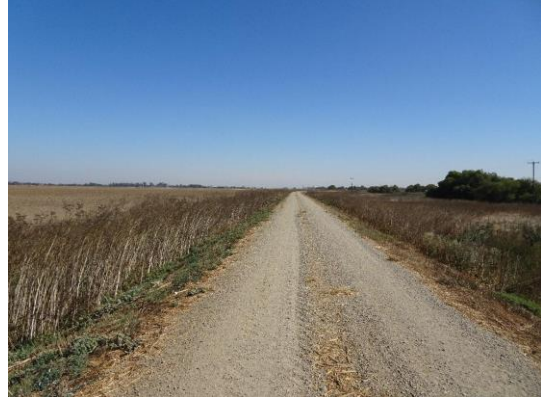
Photo 1 of 3 : UCIP_SP_2022_70667_90738.jpg

Comment Code						
Inspector Comment						
FS_ID:70667 DS_ID:19618 EP_NO: N/A Repair Type: Urgent Crossing Status: Found UCIP Comments: 10/20/2020 Record has been updated from Non-Urgent to Urgent. DWR DMP has found integrity issues, LOF between 5 and 6. Crossing will be monitored until funding becomes available to address. Topography of WS toe has changed over time with sediment build-up preventing proper drainage. At the pipe outlet there is a gradual ground elevation change that causes the water to pond against the flap gate. No permit was found authorizing this encroachment. CVFPB will need to review crossing to determine owner. (B. Singh - GEI, O. Magana - DWR UCIP)04/08/2014 Dense vegetation limits the inspector's visibility to identify signs of pipe failure (leaks) along the slope. Recommend removing vegetation along pipe alignment to conduct proper inspection of structure and appurtenances. (W. Wylie - DWR UCIP) FIELD_STRUCT_DESC: 24-inch corrugated metal (CM) gravity drainage pipe through the levee, 8.0 feet below the crown. Flap gate on the waterside (WS) end. Brass cap No. 80 bench mark (BM) on the headwall on the landside (LS). [Additional Reference(s): DWR Levee Log, 2002, (HLM 7.46). USACE San Joaquin O&M Manual, Unit No. 601, Part No. 1, (SJR601.1), 1967, Revised 25 May 2011, (HLM 7.46)]. FS Date: 10/20/2020

Overview of levee crown, looking US

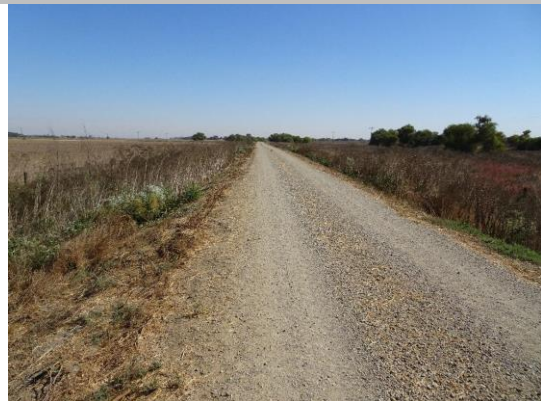
Photo 1 of 3 : UCIP_SP_2022_70668_90744.jpg

FS_ID:70668
 DS_ID:19619
 EP_NO: N/A
 Repair Type: Urgent
 Crossing Status: Found
 UCIP Comments: 10/20/2020 Record has been updated from Non-Urgent to Urgent. Sloughing observed on the LS slope above headwall. DWR DMP has found integrity issues, LOF between 5 and 6. Crossing will be monitored until funding becomes available to address. No permit was found authorizing this encroachment. CVFPB will need to review crossing to determine owner. (B. Singh - GEI, O. Magana - DWR UCIP)04/08/2014 Dense vegetation limits the inspector's visibility to identify signs of pipe failure (leaks) along the slope. Recommend removing vegetation along pipe alignment to conduct proper inspection of structure. (W. Wylie - DWR UCIP)
 FIELD_STRUCT_DESC: 24-inch corrugated metal (CM) gravity drainage pipe through the levee, 10.0 feet below the crown. Flap gate on the waterside (WS) end. Brass cap No. 80 bench mark (BM) on the headwall on the landside (LS). [Additional Reference(s): DWR Levee Log, 2002, (HLM 7.70). USACE San Joaquin O&M Manual, Unit No. 601, Part No. 1, (SJR601.1), 1967, Revised 25 May 2011, (HLM 7.69)].

Overview of levee crown, looking US

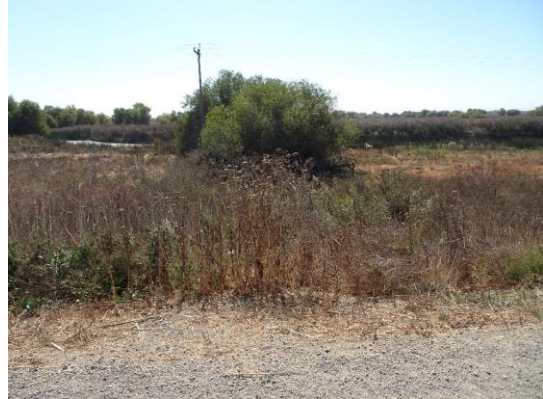
Photo 2 of 3 : UCIP_SP_2022_70668_90746.jpg

WS view: View toward WS toe

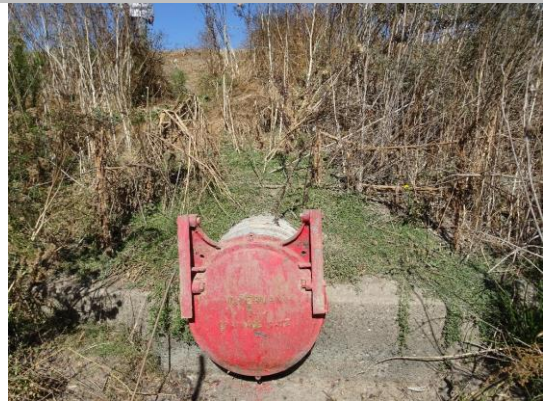
Photo 3 of 3 : UCIP_SP_2022_70668_90743.jpg

WS view: Pipe, headwall, and flapgate on WS toe

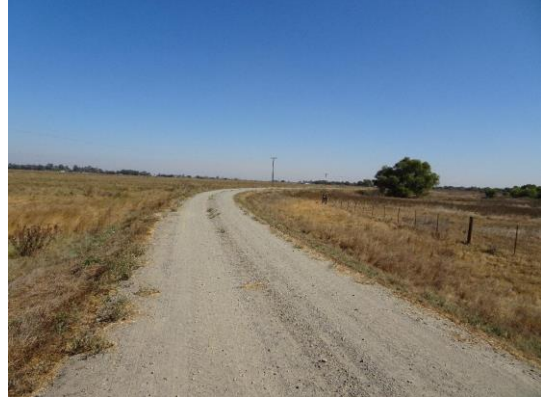
Photo 1 of 3 : UCIP_SP_2022_70669_92400.jpg

Comment Code					
Inspector Comment					
FS_ID:70669 DS_ID:19620 EP_NO: N/A Repair Type: Non-Urgent Crossing Status: Found UCIP Comments: 10/20/2020 Record remains Non-Urgent. DWR DMP has found integrity issues, LOF between 4 and 5. Corrosion in pipe visible on the LS toe. Crossing will be monitored until funding becomes available for rehabilitation. No permit was found authorizing this encroachment. CVFPB will need to review crossing to determine owner. (B. Singh - GEI, O. Magana - DWR UCIP)04/09/2014 Dense vegetation limits the inspector's visibility to identify signs of pipe failure (leaks) along the slope. Recommend removing vegetation along pipe alignment to conduct proper inspection of structure. (W. Wylie - DWR UCIP) FIELD_STRUCT_DESC: 24-inch corrugated metal (CM) gravity drainage pipe through the levee, 8.0 feet below the crown. Flap gate on the waterside (WS) end. Brass cap No. 80 bench mark (BM) on the headwall on the landside (LS). [Additional Reference(s): DWR Levee Log, 2002, (HLM 8.09). USACE San Joaquin O&M Manual, Unit No. 601, Part No. 1, (SJR601.1), 1967, Revised 25 May 2011, (HLM 8.07)]. FS Date: 10/20/2020

Overview of levee crown, looking U/S from several hundred feet away from crossing.

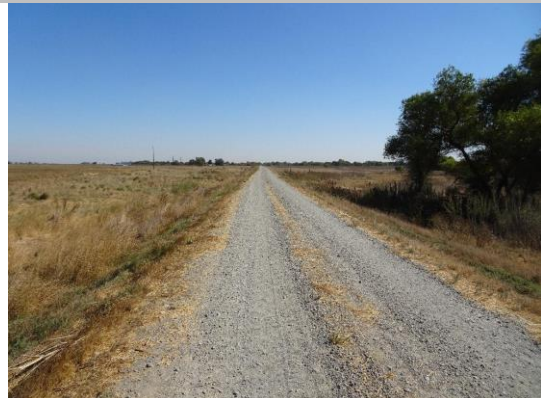
Photo 2 of 3 : UCIP_SP_2022_70669_90750.jpg

Overview of levee crown, looking US

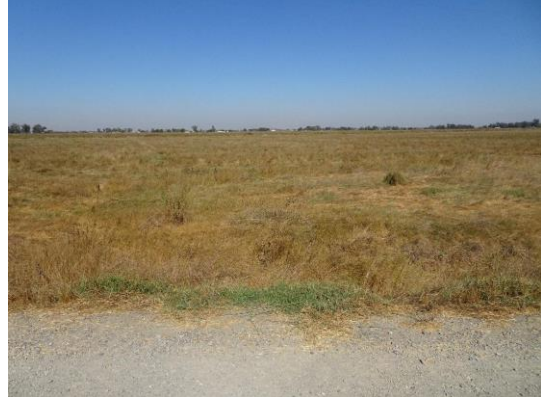
Photo 3 of 3 : UCIP_SP_2022_70669_90751.jpg

LS toe from levee crown

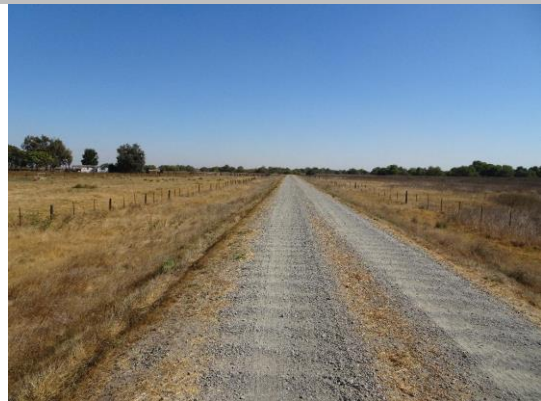
Photo 1 of 3 : UCIP_SP_2022_70670_90757.jpg

FS_ID:70670
DS_ID:19621
EP_NO: N/A
Repair Type: Non-Urgent
Crossing Status: Found
UCIP Comments: 10/20/2020 Record remains Non-Urgent. DWR DMP has found integrity issues, LOF between 4 and 5. Crossing will be monitored until funding becomes available for rehabilitation. No permit was found authorizing this encroachment. CVFPB will need to review crossing to determine owner. (B. Singh - GEI, O. Magana - DWR UCIP)04/09/2014 Dense vegetation limits the inspector's visibility to identify signs of pipe failure (leaks) along the slope. Recommend removing vegetation along pipe alignment to conduct proper inspection of structure. Sediment buildup at landward toe. (W. Wylie - DWR UCIP) FIELD_STRUCT_DESC: 24-inch corrugated metal (CM) gravity drainage pipe through the levee, 9.5 feet below the crown. Flap gate on the waterside (WS) end. Brass cap No. 80 bench mark (BM) on the headwall on the landside (LS). [Additional Reference(s): DWR Levee Log, 2002, (HLM 8.43). USACE San Joaquin O&M Manual, Unit No. 601, Part No. 1, (SJR601.1), 1967, Revised 25 May 2011, (HLM 8.41)]. FS Date: 10/20/2020

Overview of levee crown, looking US

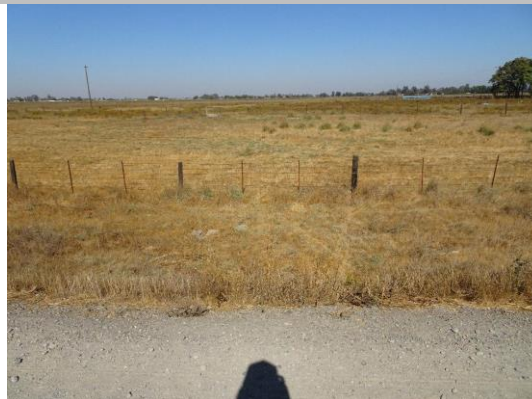
Photo 2 of 3 : UCIP_SP_2022_70670_90758.jpg

LS view: View of LS toe from levee crown

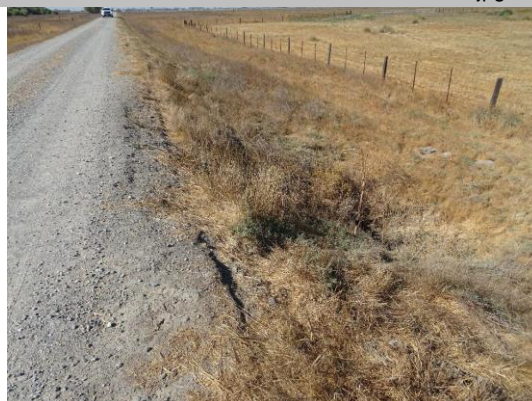
Photo 3 of 3 : UCIP_SP_2022_70670_92416.jpg

LS view: overview of LS slope profile.

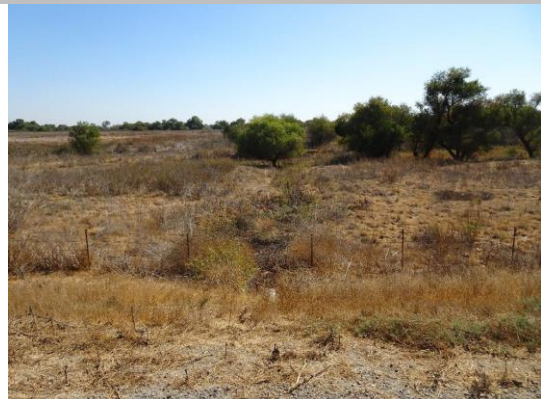
Photo 2 of 3 : UCIP_SP_2022_70672_90772.jpg

WS view: Pipe and flapgate visible on WS toe

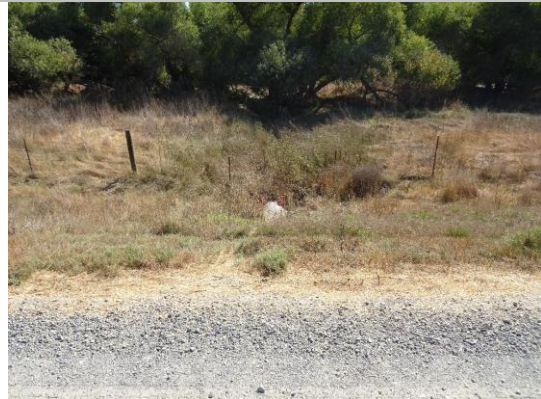
Photo 2 of 3 : UCIP_SP_2022_70673_90780.jpg

WS view: Pipe and flapgate visible at WS toe

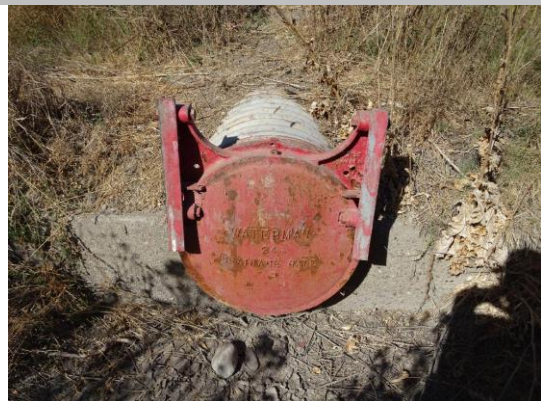
Photo 3 of 3 : UCIP_SP_2022_70673_90776.jpg

WS view: Pipe, flapgate, and headwall at WS toe

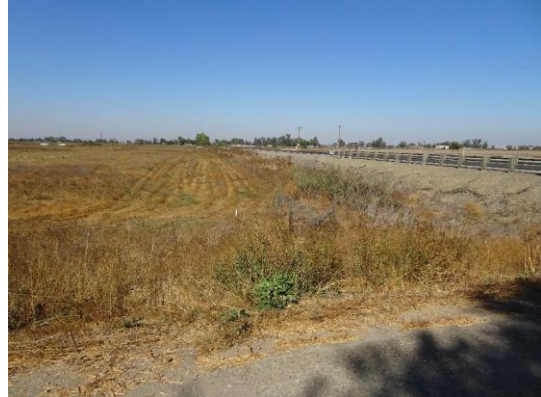
Photo 1 of 3 : UCIP_SP_2022_70674_90783.jpg

Comment Code					
Inspector Comment					
FS_ID:70674 DS_ID:19624 EP_NO: 12156 Repair Type: Urgent Crossing Status: Found UCIP Comments: 10/20/2020 Record remains Urgent. There is no operating gate that will prevent flows from the WS to LS. Dense vegetation prevented a full inspection of this crossing. Need to contact owner to clear the dense vegetation on both the WS and the LS to be able to perform proper inspection of crossing. DWR DMP has completed a geophysical study in this area and plans to complete an internal inspection of this pipe. The pipe is scheduled for an internal inspection in 2021. (B. Singh - GEI, O. Magana - DWR UCIP)11/01/2018 Dense vegetation prevented a full inspection of this crossing. Assumed crossing remains the same as the 2016 inspection. Crossing remains Urgent due to signs of pipe being rusted through visible from the WS. Need to contact owner to clear the dense vegetation on both the WS and the LS to be able to perform proper inspection of crossing. (O. Magana - DWR UCIP)07/19/2016 same as previous inspection--pipe rusted through. Sediment visible inside LS pipe; walkway wood panels have dry rot and appears to be unsafe to use. (O. Magana - DWR UCIP)04/09/2014 Slide gate rusted through and open on WS toe. Inlet appears to be obscured or covered in soil at LS toe. Also dense vegetation on waterward and landward sides. Need to contact owner to contact CVFPB to address issue. (W. Wylie - DWR UCIP) FIELD_STRUCT_DESC: 30-inch reinforced concrete (RC) gravity drainage pipe containing a 26-inch steel pipe through the levee, 7.3 feet below the crown. Annular space grouted. Two concrete cutoff walls in the center of the levee. Slide gate with elevated walkway access on the waterside (WS) end. 6-inch-thick concrete headwall on the WS end. Concrete wing walls on each end. (30-inch drainage pipe with a valve authorized under Permit No. 12156, 1977 - Merquin County Water District. Additional Related Permit(s): Permit No. 12156-A, 1978 - Merquin County Water District). [Additional Reference(s): DWR Levee Log, 2002, (HLM 9.01)]. FS Date: 10/20/2020

LS view: View of LS toe from levee crown

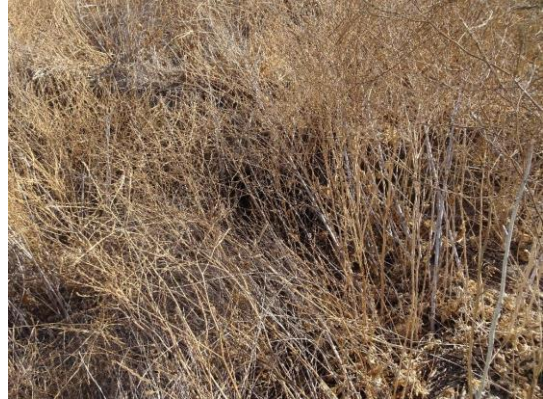
Photo 2 of 3 : UCIP_SP_2022_70674_92418.jpg

LS view: concrete headwall slightly visible on LS.

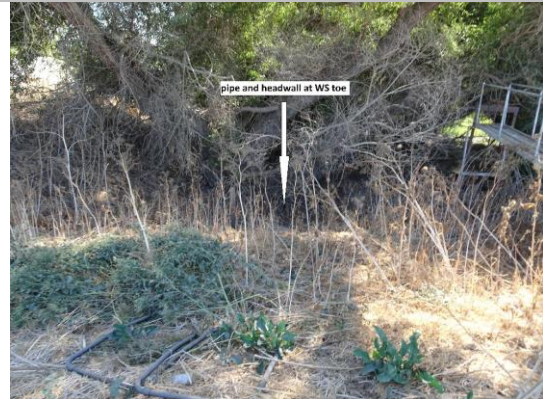
Photo 3 of 3 : UCIP_SP_2022_70675_90791.jpg

FS_ID:70675
DS_ID:19625
EP_NO: N/A
Repair Type: Non-Urgent
Crossing Status: Found
UCIP Comments: 10/20/2020 Record remains Non-Urgent. As in previous inspection, dense vegetation inhibited proper inspection of the pipe and slope. No permit was found authorizing this encroachment. CVFPB will need to review crossing to determine owner. DWR DMP internal inspection is pending and scheduled for 2021. (B. Singh - GEI, O. Magana - DWR UCIP)04/09/2014 Dense vegetation limits the inspector's visibility to identify signs of pipe failure (leaks) along the slope. Recommend removing vegetation along pipe alignment to conduct proper inspection of structure. Some sediment buildup in pipe. (W. Wylie - DWR UCIP)
FIELD_STRUCT_DESC: 36-inch corrugated metal (CM) gravity drainage pipe through the levee, 10.0 feet below the crown. Flap gate on the waterside (WS) end. Brass cap No. 80 bench mark (BM) on the headwall on the landside (LS). [Additional Reference(s): DWR Levee Log, 2002, (HLM 9.01). USACE San Joaquin O&M Manual, Unit No. 601, Part No. 1, (SJR601.1), 1967, Revised 25 May 2011, (HLM 9.00)].

WS view: Pipe visible at WS toe, but low accessibility due to vegetation.

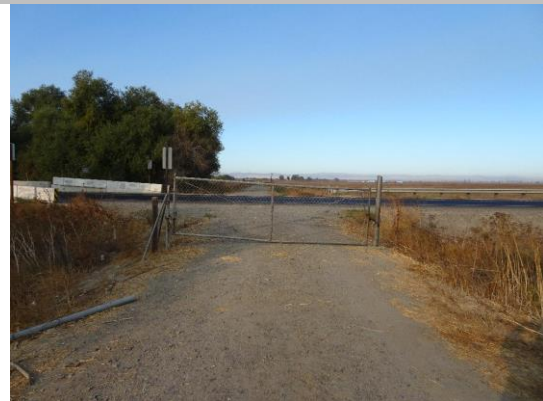
Photo 1 of 3 : UCIP_SP_2022_70676_90906.jpg

FS_ID:70676
DS_ID:19626
EP_NO: N/A
Repair Type: Non-Urgent
Crossing Status: Found
UCIP Comments: 10/21/2020 Record remains Non-Urgent. Dense vegetation inhibited proper inspection of pipe condition. No permit was found authorizing this encroachment. CVFPB will need to review crossing to determine owner. DWR DMP internal inspection is pending and scheduled for 2021. (B. Singh - GEI, O. Magana - DWR UCIP)04/09/2014 Dense vegetation limits the inspector's visibility to identify signs of pipe failure (leaks) along the slope. Recommend removing vegetation along pipe alignment to conduct proper inspection of structure. (W. Wylie - DWR UCIP)
FIELD_STRUCT_DESC: 24-inch corrugated metal (CM) gravity drainage pipe through the levee, 10.0 feet below the crown. Flap gate on the waterside (WS) end. Brass cap No. 80 bench mark (BM) on the headwall on the landside (LS). [Additional Reference(s): DWR Levee Log, 2002, (HLM 9.03). USACE San Joaquin O&M Manual, Unit No. 601, Part No. 1, (SJR601.1), 1967, Revised 25 May 2011, (HLM 9.03)].

Overview of levee crown looking downstream.

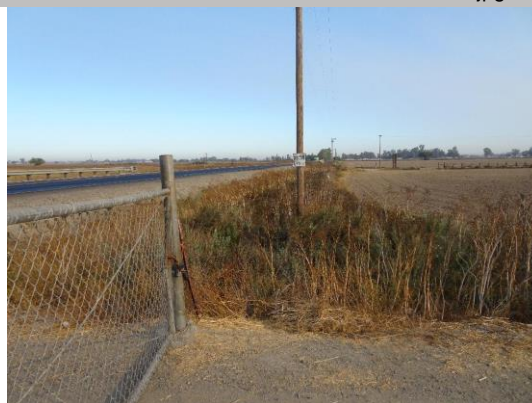
Photo 3 of 3 : UCIP_SP_2022_70676_90907.jpg

LS view: overview of LS

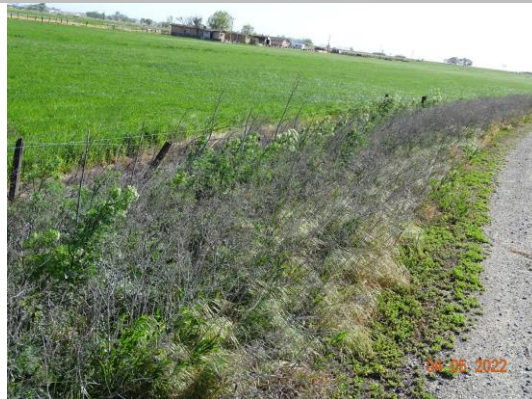
Photo 1 of 1 : SP_2022_NA0010_118_129_20220412_00304.jpg

LM Start	8.99	Rating **	U	Issue No.	129
LM End	9.64	Issue Type +	Ma	Location *	LS
Category	Earthen Levee			GPS Latitude/Longitude	
				Start	End
Item	Vegetation			37.297497 °	37.294875 °
				-120.851069 °	-120.840601 °
DWR ID	DWR_NA0010_01_s_2022_129				
Comment Code					
V1 : Control annual grass and weeds on the levee slopes and easements.					
Inspector Comment

View of vegetation on the landside slope. (Spring 2022)

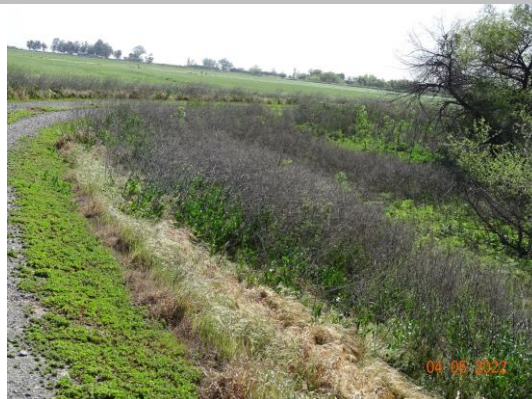
Photo 1 of 1 : SP_2022_NA0010_118_130_20220412_00305.jpg

LM Start	9.00	Rating **	U	Issue No.	130
LM End	9.13	Issue Type +	Ma	Location *	WS
Category	Earthen Levee			GPS Latitude/Longitude	
				Start	End
Item	Vegetation			37.297503 °	37.296435 °
				-120.850882 °	-120.849015 °
DWR ID	DWR_NA0010_01_s_2022_130				
Comment Code					
V1 : Control annual grass and weeds on the levee slopes and easements.					
Inspector Comment

Looking upstream along the waterside slope. (Spring 2022)

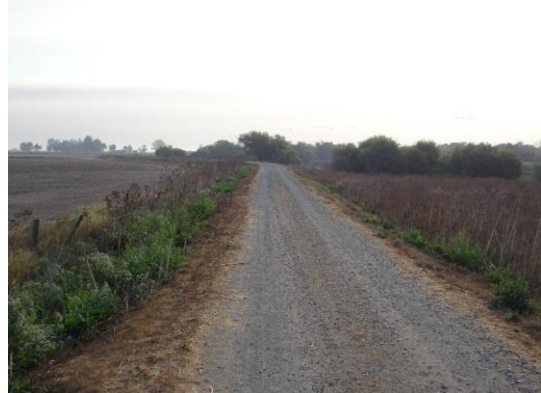
Photo 1 of 3 : UCIP_SP_2022_70677_90910.jpg

Comment Code						
Inspector Comment						
FS_ID:70677 DS_ID:19627 EP_NO: N/A Repair Type: Urgent Crossing Status: Found UCIP Comments: 10/21/2020 Record has been updated from Non-Urgent to Urgent. DWR DMP has found integrity issues, LOF between 5 and 6. Scouring observed about 2 feet downstream of pipe at WS toe. Crossing will be monitored until funding becomes available to address. No permit was found authorizing this encroachment. CVFPB will need to review crossing to determine owner. (B. Singh - GEI, O. Magana - DWR UCIP)04/09/2014 Dense vegetation limits the inspector's visibility to identify signs of pipe failure (leaks) along the slope. Recommend removing vegetation along pipe alignment to conduct proper inspection of structure. (W. Wylie - DWR UCIP) FIELD_STRUCT_DESC: 24-inch corrugated metal (CM) gravity drainage pipe through the levee, 8.6 feet below the crown. Concrete drop inlet at the landside (LS) toe. Flap gate on the waterside (WS) end. Brass cap No. 80 bench mark (BM) on the headwall on the LS. [Additional Reference(s): DWR Levee Log, 2002, (HLM 9.39). USACE San Joaquin O&M Manual, Unit No. 601, Part No. 1, (SJR601.1), 1967, Revised 25 May 2011, (HLM 9.37)]. FS Date: 10/21/2020

Overview of levee crown

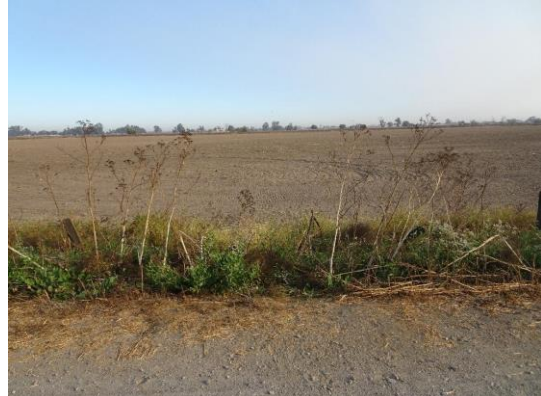
Photo 2 of 3 : UCIP_SP_2022_70677_90912.jpg

LS view: overview of LS

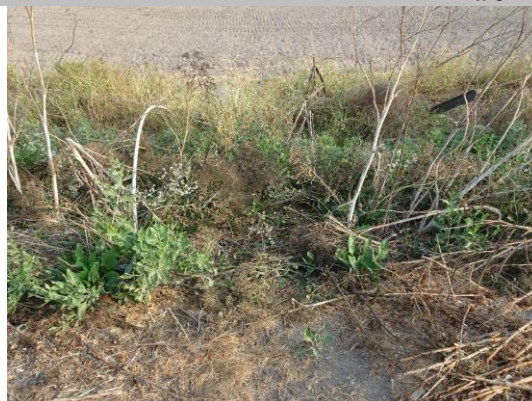
Photo 3 of 3 : UCIP_SP_2022_70677_90911.jpg

LS view: View of LS slope from levee crown

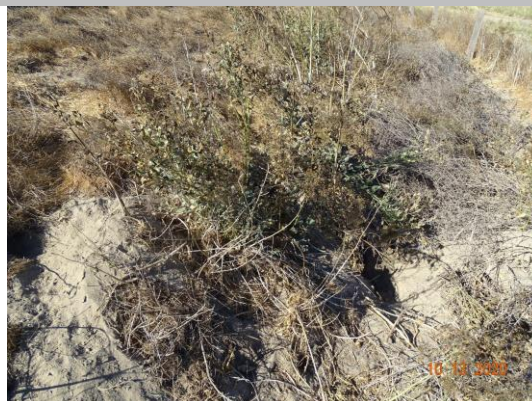
Photo 1 of 1 : SP_2022_NA0010_118_101_20220308_00008.jpg

LM Start	9.56	Rating **	M	Issue No.	101
LM End	9.56	Issue Type +	Ma	Location *	LS
Category	Earthen Levee			GPS Latitude/Longitude	
				Start	End
Item	Animal Control			37.295541 °	37.295541 °
				-120.841739 °	-120.841739 °
DWR ID	DWR_NA0010_01_f_2020_101				
Comment Code					
A1 : Exterminate rodents and backfill and compact or grout burrows.					
Inspector Comment

Rodent burrows in the landside slope. (Fall 2020)

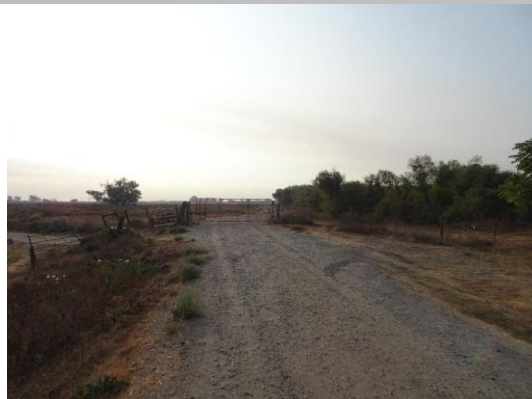
Photo 1 of 3 : UCIP_SP_2022_70678_90915.jpg

FS_ID:70678
DS_ID:19628
EP_NO: N/A
Repair Type: Non-Urgent
Crossing Status: Found
UCIP Comments: 10/21/2020 Record has been updated from No Action Needed to Non-Urgent. No permit was found authorizing this encroachment. CVFPB will need to review crossing to determine owner. DWR DMP has not found internal issues, LOF between 1 and 2. Recommend inspection in 5 years. (B. Singh - GEI, O. Magana - DWR UCIP)
FIELD_STRUCT_DESC: 24-inch corrugated metal (CM) gravity drainage pipe through the levee, 4.5 feet below the crown. Flap gate on the waterside (WS) end. Brass cap No. 80 bench mark (BM) on the headwall on the landside (LS). [Additional Reference(s): DWR Levee Log, 2002, (HLM 9.68). USACE San Joaquin O&M Manual, Unit No. 601, Part No. 1, (SJR601.1), 1967, Revised 25 May 2011, (HLM 9.67)].
FS Date: 10/21/2020

Overview of levee crown

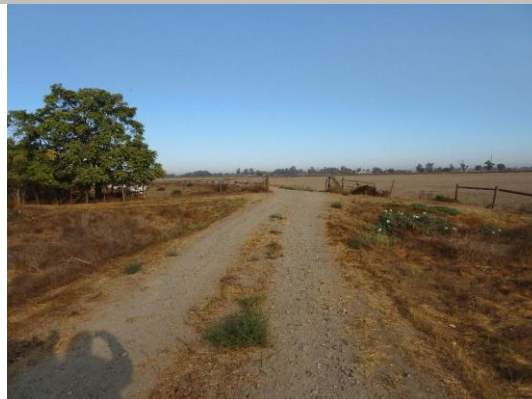
Photo 2 of 3 : UCIP_SP_2022_70678_92422.jpg

Overview of levee crown looking downstream towards pipe crossing.

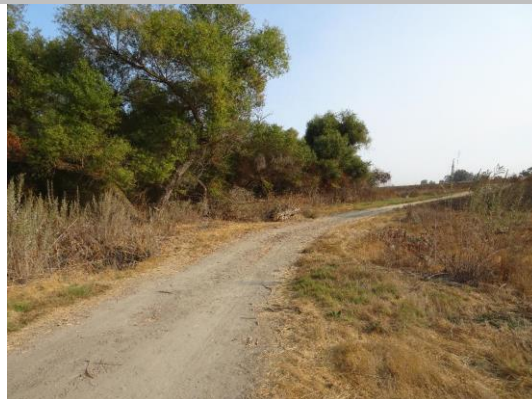
Photo 2 of 3 : UCIP_SP_2022_70679_91040.jpg

Overview of levee crown at crossing

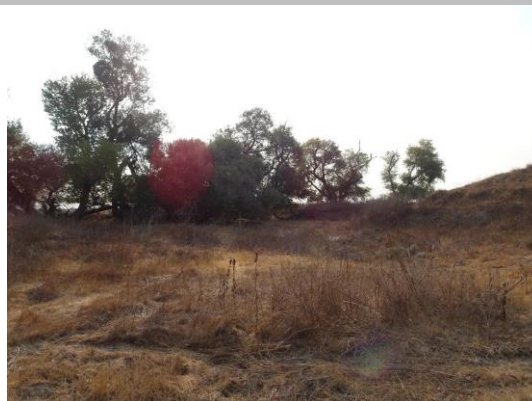
Photo 3 of 3 : UCIP_SP_2022_70679_92745.jpg

LM Start	9.86	Rating **	M	Issue No.	52 (cont)
LM End	9.86	Issue Type +	En	Location *

Overview of where levee is no longer present. Location historic levee break, levee absent.

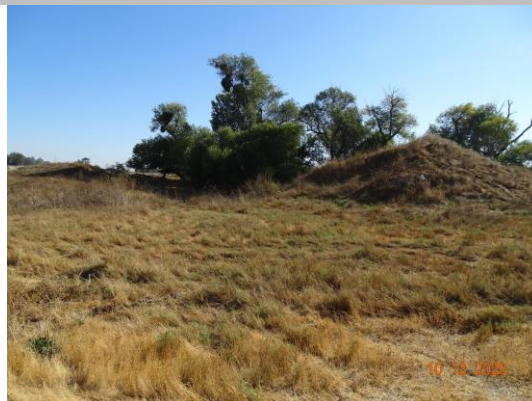
Photo 1 of 1 : SP_2022_NA0010_118_112_20220308_00014.jpg

LM Start	9.89	Rating **	A/W	Issue No.	112
LM End	9.90	Issue Type +	Ma	Location *	CR
Category	Earthen Levee			GPS Latitude/Longitude	
				Start	End
Item	Erosion / Bank Caving			37.291796 °	37.291581 °
				-120.839497 °	-120.839718 °
DWR ID	DWR_NA0010_01_f_2017_112				
Comment Code					
E1 : Note and monitor erosion site.					
Inspector Comment					
Landowner degraded levee in the 1970's because water on LS was flooding his property. Landowner has prevented efforts to restore levee. LMA has stated that no water from the waterside of the levee has ever backed up through the degraded levee and caused flooding.

Looking east at the levee breach. (Fall 2020)

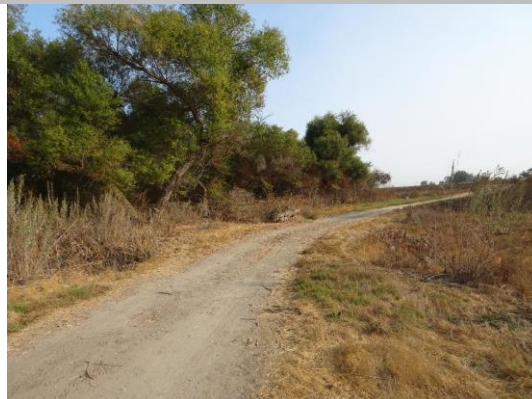
Photo 2 of 3 : UCIP_SP_2022_70680_91046.jpg

Overview access road looking downstream.

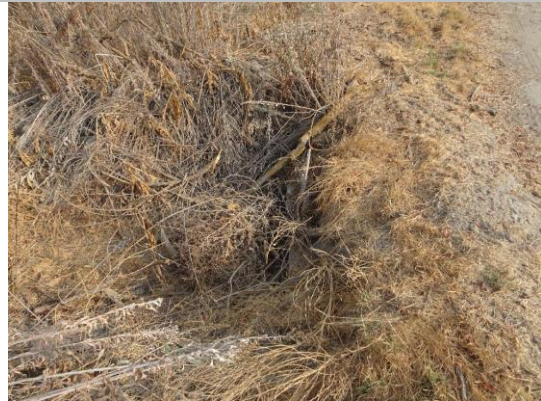
Photo 3 of 3 : UCIP_SP_2022_70680_91047.jpg

LM Start	9.89	Rating **	M	Issue No.	53 (cont)
LM End	9.89	Issue Type +	En	Location *	
Category	Supplemental		GPS Latitude/Longitude		
			Start	End	
Item	DWR UCIP Field Study		37.291667 °	37.291667 °	
			-120.839224 °	-120.839224 °	
DWR ID	19556

Culverts underneath access road visible on WS

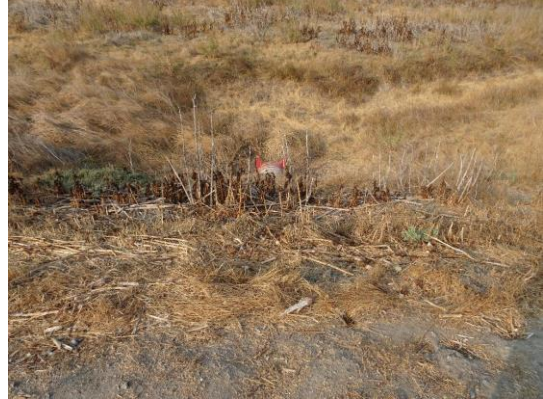
Photo 2 of 3 : UCIP_SP_2022_70681_90923.jpg

LM Start	10.20	Rating **	M	Issue No.	54 (cont)
LM End	10.20	Issue Type +	Ma	Location *	
Category	Supplemental			GPS Latitude/Longitude	
				Start	End
Item	DWR UCIP LMA Responsibility			37.287511 °	37.287511 °
				-120.840251 °	-120.840251 °
DWR ID	19629

WS view: Pipe and flapgate visible at WS toe

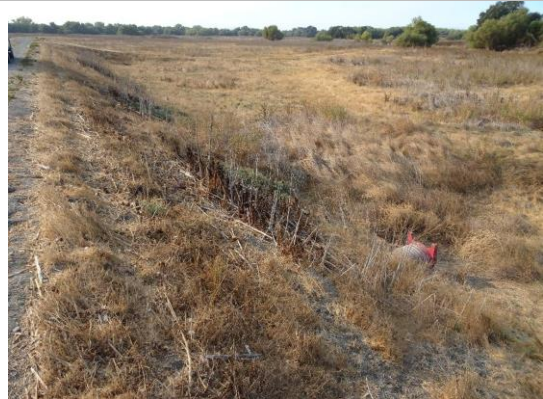
Photo 3 of 3 : UCIP_SP_2022_70681_90926.jpg

LM Start	10.20	Rating **	M	Issue No.	54 (cont)
LM End	10.20	Issue Type +	Ma	Location *

WS view: WS slope profile

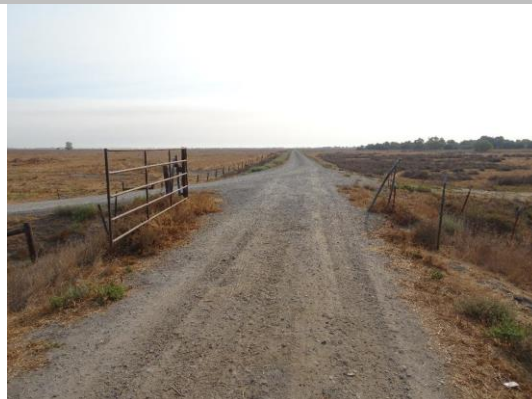
Photo 2 of 3 : UCIP_SP_2022_70682_90999.jpg

Overview of levee crown looking upstream

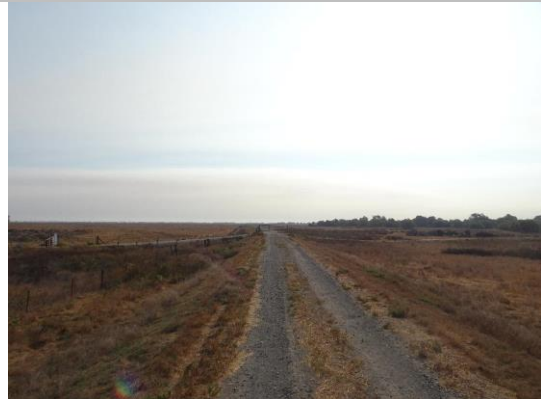
Photo 1 of 3 : UCIP_SP_2022_70683_92770.jpg

LM Start	10.69	Rating **	M	Issue No.	56
LM End	10.69	Issue Type +	Ma	Location *	
Category	Supplemental		GPS Latitude/Longitude		
			Start	End	
Item	DWR UCIP LMA Responsibility		37.283710 °	37.283710 °	
			-120.833329 °	-120.833329 °	
DWR ID	19631

FS_ID:70683
 DS_ID:19631
 EP_NO: N/A
 Repair Type: Non-Urgent
 Crossing Status: Found
 UCIP Comments: 10/21/2020 Record has been updated from No Action Needed to Non-Urgent. DWR DMP has found integrity issues, LOF between 4 and 5. Crossing will be monitored until funding becomes available for rehabilitation. No permit was found authorizing this encroachment. CVFPB will need to review crossing to determine owner. Pipe material changes from CMP on the WS to concrete on the LS. (B. Singh - GEI, O. Magana - DWR UCIP)
 FIELD_STRUCT_DESC: 24-inch corrugated metal (CM) gravity drainage pipe through the levee, 7.0 feet below the crown. Flap gate on the waterside (WS) end. Brass cap No. 67 bench mark (BM) on the headwall on the landside (LS). Pipe material changes from CMP on the WS to concrete on the LS. [Additional Reference(s): DWR Levee Log, 2002, (HLM 10.74). USACE San Joaquin O&M Manual, Unit No. 601, Part No. 1, (SJR601.1), 1967, Revised 25 May 2011, (HLM 10.72)].

Overview of levee crown looking upstream towards crossings.

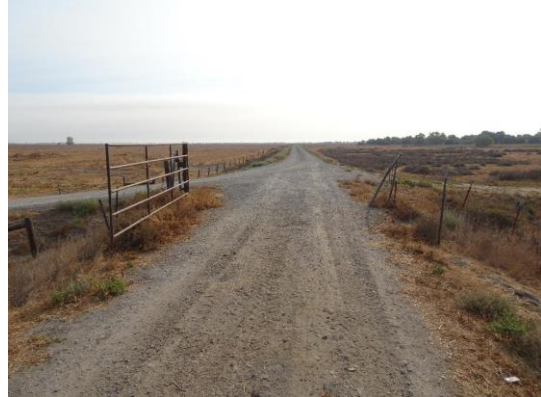
Photo 2 of 3 : UCIP_SP_2022_70683_91009.jpg

LM Start	10.69	Rating **	M	Issue No.	56 (cont)
LM End	10.69	Issue Type +	Ma	Location *	
Category	Supplemental		GPS Latitude/Longitude		
			Start	End	
Item	DWR UCIP LMA Responsibility		37.283710 °	37.283710 °	
			-120.833329 °	-120.833329 °	
DWR ID	19631

Overview of levee crown looking upstream

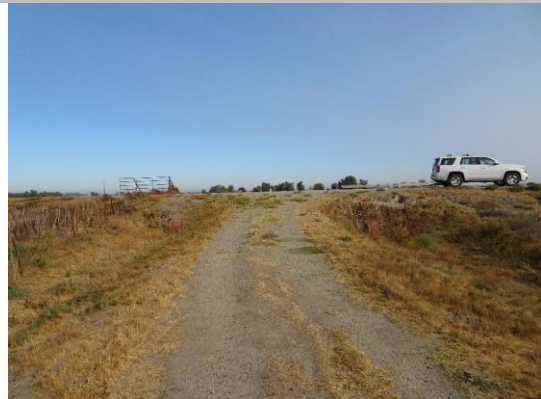
Photo 3 of 3 : UCIP_SP_2022_70683_92766.jpg

LM Start	10.69	Rating **	M	Issue No.	56 (cont)
LM End	10.69	Issue Type +	Ma	Location *

WS view: ramp located on WS with two crossing on either side. This crossing is located on the right side.

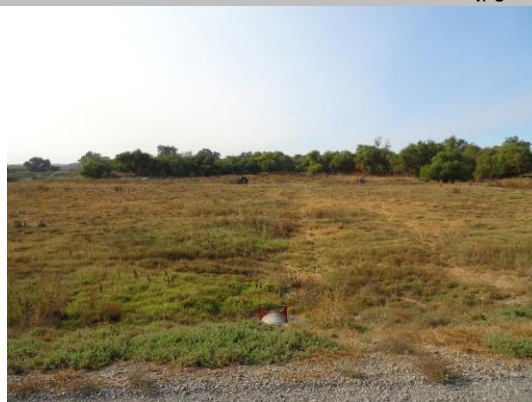
Photo 2 of 3 : UCIP_SP_2022_70684_90930.jpg

WS view: overview of WS

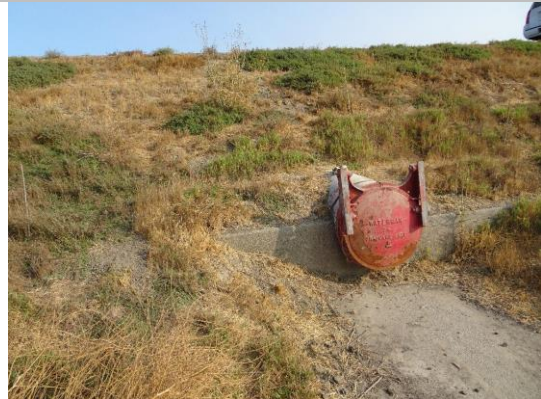
Photo 3 of 3 : UCIP_SP_2022_70684_90932.jpg

LM Start	10.98	Rating **	M	Issue No.	57 (cont)
LM End	10.98	Issue Type +	Ma	Location *	
Category	Supplemental		GPS Latitude/Longitude		
			Start	End	
Item	DWR UCIP LMA Responsibility		37.282627 °	37.282627 °	
			-120.828233 °	-120.828233 °	
DWR ID	19632

WS view: overview of WS slope

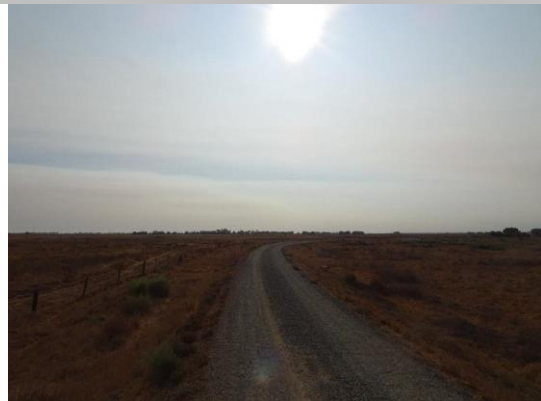
Photo 1 of 3 : UCIP_SP_2022_70685_92800.jpg

LM Start	11.14	Rating **	M	Issue No.	58
LM End	11.14	Issue Type +	Ma	Location *	
Category	Supplemental		GPS Latitude/Longitude		
			Start	End	
Item	DWR UCIP LMA Responsibility		37.281813 °	37.281813 °	
			-120.825409 °	-120.825409 °	
DWR ID	19633

FS_ID:70685
DS_ID:19633
EP_NO: N/A
Repair Type: Non-Urgent
Crossing Status: Found
UCIP Comments: 10/21/2020 Record has been updated from No Action Needed to Non-Urgent. No permit was found authorizing this encroachment. CVFPB will need to review crossing to determine owner. DWR DMP has not found internal issues, LOF between 1 and 2. Recommend inspection in 5 years. (B. Singh - GEI, O. Magana - DWR UCIP)
FIELD_STRUCT_DESC: 24-inch corrugated metal (CM) gravity drainage pipe through the levee, 5.0 feet below the crown. Flap gate on the waterside (WS) end. Brass cap No. 65 bench mark (BM) on the headwall on the landside (LS). [Additional Reference(s): DWR Levee Log, 2002, (HLM 11.20). USACE San Joaquin O&M Manual, Unit No. 601, Part No. 1, (SJR601.1), 1967, Revised 25 May 2011, (HLM 11.18)].
FS Date: 10/21/2020

Overview of levee curve towards pipe crossing, looking upstream

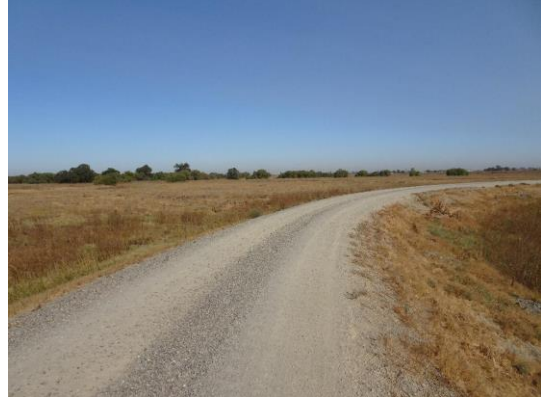
Photo 1 of 3 : UCIP_SP_2022_70686_90940.jpg

Comment Code						
Inspector Comment						
FS_ID:70686 DS_ID:19814 EP_NO: N/A Repair Type: Non-Urgent Crossing Status: Found UCIP Comments: 10/21/2020 Record has been updated from No Action Needed to Non-Urgent. Steep slopes prevented further inspection of the WS and LS toes. No permit was found authorizing this encroachment. CVFPB will need to review crossing to determine owner. DWR DMP has not found internal issues, LOF between 1 and 2. Recommend inspection in 5 years. (B. Singh - GEI, O. Magana - DWR UCIP) FIELD_STRUCT_DESC: 24-inch corrugated metal (CM) gravity drainage pipe through the levee, 12.0 feet below the crown. Two metal cutoff walls. Flap gate, concrete saddle, and apron on the waterside (WS) end. Concrete headwall on the landside (LS) end. [Additional Reference(s): DWR Levee Log, 2002. USACE San Joaquin O&M Manual, Unit No. 601, Part No. 1, (SJR601.1), 1967, Revised 25 May 2011, (recorded as Unit 6, HLM 0.05, should be Unit 1, HLM 11.37)]. FS Date: 10/21/2020

LM Start	11.37	Rating **	M	Issue No.	59 (cont)
LM End	11.37	Issue Type +	Ma	Location *

Overview of levee crown looking upstream.

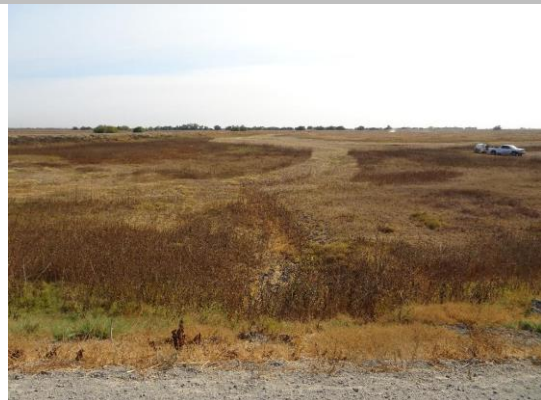
Photo 2 of 3 : UCIP_SP_2022_70686_90941.jpg

LS view: overview of LS

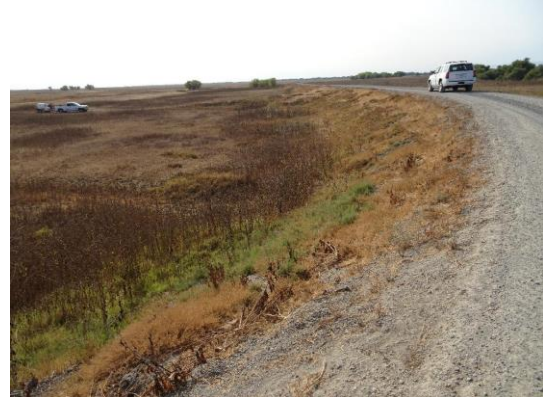
Photo 3 of 3 : UCIP_SP_2022_70686_92834.jpg

LM Start	11.37	Rating **	M	Issue No.	59 (cont)
LM End	11.37	Issue Type +	Ma	Location *	
Category	Supplemental		GPS Latitude/Longitude		
			Start	End	
Item	DWR UCIP LMA Responsibility		37.275518 °	37.275518 °	
			-120.826052 °	-120.826052 °	
DWR ID	19814

LS view: profile view of LS slope.
