**Flood Control Project Maintenance
Levee Inspections
LMA District Cover Sheet**

Lower San Joaquin Levee District

**Flood Control Project Maintenance
Levee Inspections
Unit Cover Sheet**

Levee Inspection Report By Mile - Spring 2022

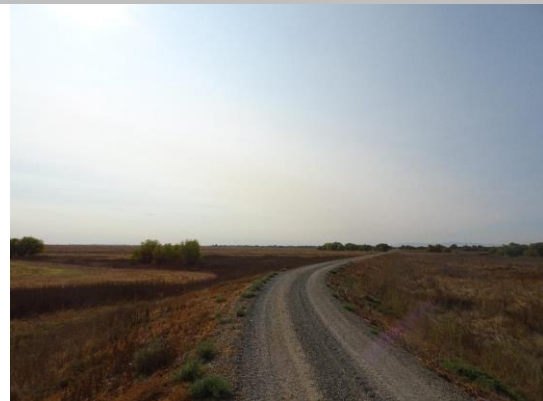
Photo 1 of 3 : UCIP_SP_2022_70687_92836.jpg

LM Start	11.49	Rating **	M	Issue No.	60
LM End	11.49	Issue Type +	Ma	Location *	
Category	Supplemental		GPS Latitude/Longitude		
			Start	End	
Item	DWR UCIP LMA Responsibility		37.273787 °	37.273787 °	
			-120.825519 °	-120.825519 °	
DWR ID	19634

FS_ID:70687
DS_ID:19634
EP_NO: N/A
Repair Type: Non-Urgent
Crossing Status: Found
UCIP Comments: 10/21/2020 Record remains Non-Urgent. Dense vegetation inhibited inspection of pipe and headwall on the LS toe. DWR DMP has found integrity issues, LOF between 4 and 5. Unable to locate pipe inlet on along the LS toe. Crossing will be monitored until funding becomes available for rehabilitation. No permit was found authorizing this encroachment. CVFPB will need to review crossing to determine owner. (B. Singh - GEI, O. Magana - DWR UCIP)04/25/2014 Need to contact owner--landward side has been buried. It appears that soil was removed from levee toe, immediately upstream, and used to pile soil at landward side at crossing. (O. Magana - DWR UCIP)
FIELD_STRUCT_DESC: 24-inch corrugated metal (CM) gravity drainage pipe through the levee, 10.0 feet below the crown. Flap gate on the waterside (WS) end. Brass cap No. 62 bench mark (BM) on the headwall on the landside (LS). [Additional Reference(s): DWR Levee Log, 2002, (HLM 11.48). USACE San Joaquin O&M Manual, Unit No. 601, Part No. 1, (SJR601.1), 1967, Revised 25 May 2011, (HLM 11.48)].

Overview of levee crown looking upstream towards pipe crossing, photo 1 of 2.

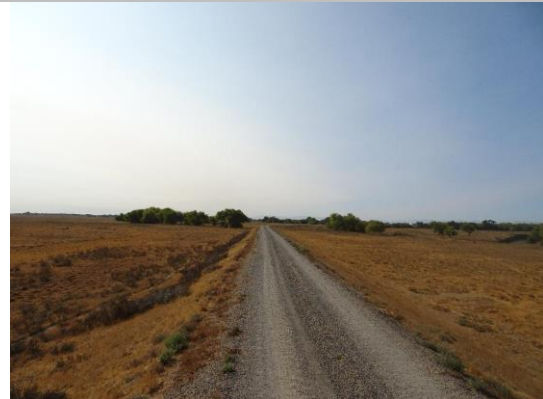
Photo 1 of 3 : UCIP_SP_2022_70688_90950.jpg

FS_ID:70688
DS_ID:19635
EP_NO: N/A
Repair Type: Non-Urgent
Crossing Status: Found
UCIP Comments: 10/21/2020 Record remains Non-Urgent. DWR DMP geophysics study found evidence of pipe at 37.269697, -120.826430 (modified levee mile coordinates 37.269657, -120.826471 using UCIP calculator). Pipe and flap gate previously found on the WS toe were covered by dry vegetation preventing proper UCIP inspection. Recommend removal of excess vegetation to conduct a proper inspection of this structure through the levee. The pipe inlet and concrete headwall are buried on the LS toe. No permit was found authorizing this encroachment. CVFPB will need to review crossing to determine owner. (B. Singh - GEI, O. Magana - DWR UCIP) 04/25/2014 Crossing is non-functional --landward side is buried. Debris found on landward side (channel). Dense vegetation found on waterward slope. Recommend contacting owner to determine status of crossing. If crossing is no longer used need to coordinate with CVFPB for proper abandonment. (O. Magana - DWR UCIP)

LM Start	11.78	Rating **	M	Issue No.	61 (cont)
LM End	11.78	Issue Type +	Ma	Location *

Overview of levee crown

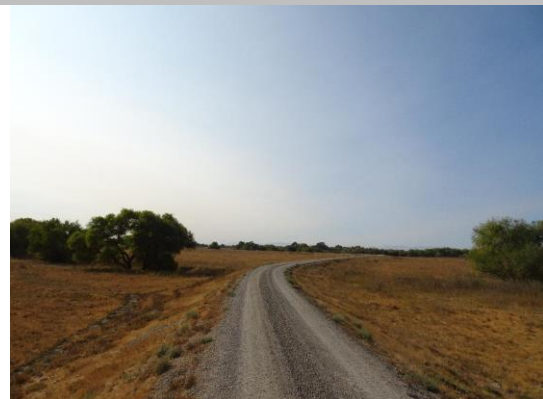
Photo 2 of 3 : UCIP_SP_2022_70688_92838.jpg

Overview of levee crown looking upstream towards pipe.

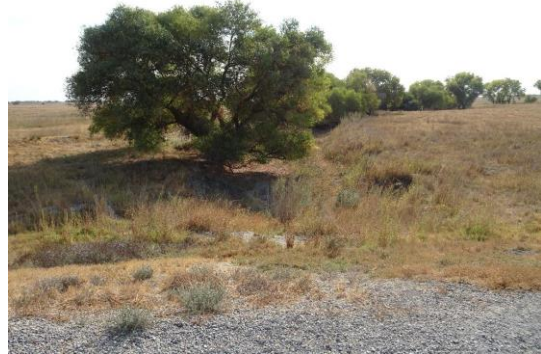
Photo 3 of 3 : UCIP_SP_2022_70688_90953.jpg

LM Start	11.78	Rating **	M	Issue No.	61 (cont)
LM End	11.78	Issue Type +	Ma	Location *	
Category	Supplemental		GPS Latitude/Longitude		
			Start	End	
Item	DWR UCIP LMA Responsibility		37.269657 °	37.269657 °	
			-120.826471 °	-120.826471 °	
DWR ID	19635

LS view: overview of LS

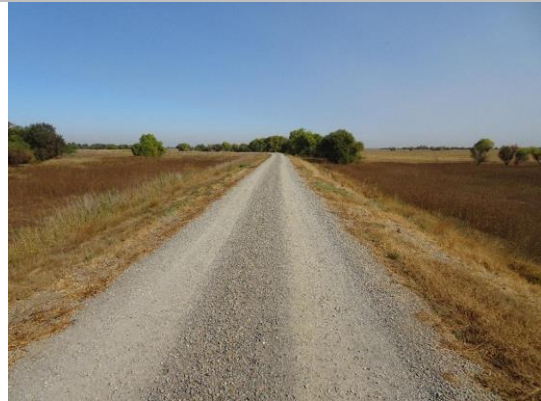
Photo 1 of 3 : UCIP_SP_2022_70689_90956.jpg

LM Start	12.12	Rating **	M	Issue No.	62
LM End	12.12	Issue Type +	Ma	Location *	
Category	Supplemental		GPS Latitude/Longitude		
			Start	End	
Item	DWR UCIP LMA Responsibility		37.265336 °	37.265336 °	
			-120.826591 °	-120.826591 °	
DWR ID	19636

FS_ID:70689
DS_ID:19636
EP_NO: N/A
Repair Type: Non-Urgent
Crossing Status: Found
UCIP Comments: 10/21/2020 Record remains Non-Urgent. Dense vegetation inhibited proper inspection of the pipe on the LS and WS toes. No permit was found authorizing this encroachment. CVFPB will need to review crossing to determine owner. DWR DMP internal inspection is pending and scheduled for 2021. (B. Singh - GEI, O. Magana - DWR UCIP)04/25/2014 Crossing is non-functional -- landward side is buried. Dense vegetation found on waterward slope. Recommend contacting owner to determine status of crossing. If crossing is no longer used need to coordinate with CVFPB for proper abandonment. (O. Magana - DWR UCIP)
FIELD_STRUCT_DESC: 24-inch corrugated metal (CM) gravity drainage pipe through the levee, 12.4 feet below the crown. Flap gate on the waterside (WS) end. Brass cap No. 60 bench mark (BM) on the headwall on the landside (LS). [Additional Reference(s): DWR Levee Log, 2002, (HLM 12.12). USACE San Joaquin O&M Manual, Unit No. 601, Part No. 1, (SJR601.1), 1967, Revised 25 May 2011, (HLM 12.11)].

Overview of levee crown looking upstream.

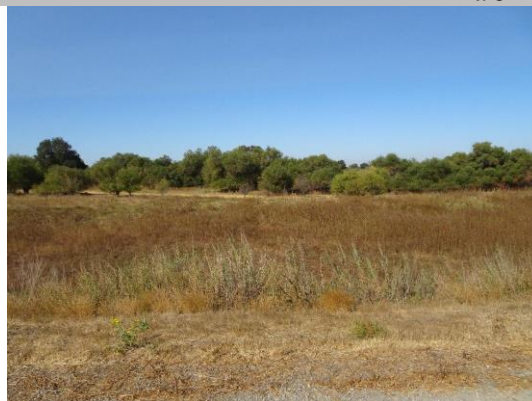
Photo 2 of 3 : UCIP_SP_2022_70689_90958.jpg

WS view: overview of WS

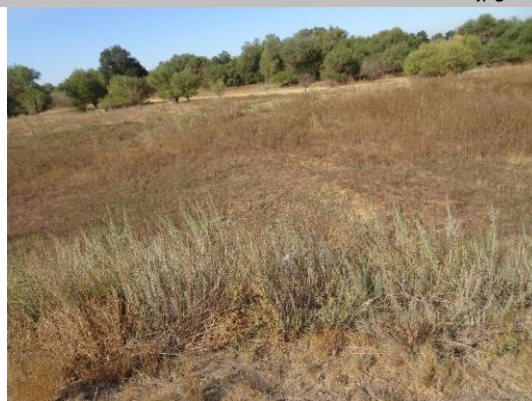
Photo 3 of 3 : UCIP_SP_2022_70689_90960.jpg

WS view: dense vegetation near WS toe.

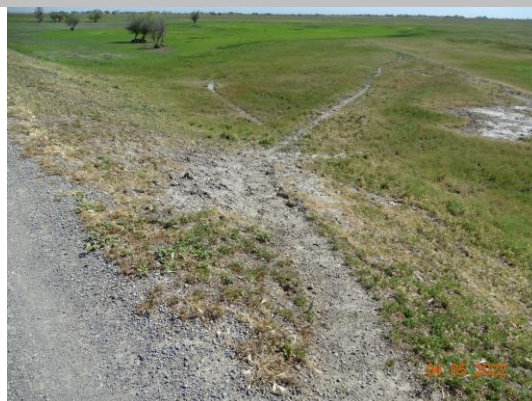
Photo 1 of 1 : SP_2022_NA0010_118_135_20220412_00307.jpg

LM Start	12.24	Rating **	A/W	Issue No.	135
LM End	12.24	Issue Type +	Ma	Location *	LS
Category	Earthen Levee			GPS Latitude/Longitude	
				Start	End
Item	Erosion / Livestock			37.263732 °	37.263732 °
				-120.827306 °	-120.827306 °
DWR ID	DWR_NA0010_01_s_2022_135				
Comment Code					
E4 : Repair the levee slope damaged by livestock and prevent large animal access.					
Inspector Comment

Livestock caused erosion on the landside slope. (Spring 2022)

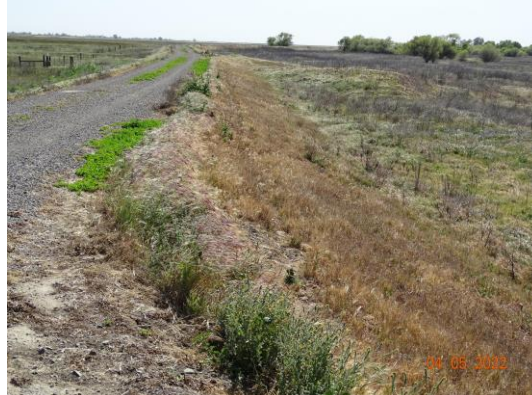
Photo 1 of 1 : SP_2022_NA0010_118_138_20220412_00309.jpg

LM Start	12.62	Rating **	M	Issue No.	138
LM End	12.81	Issue Type +	Ma	Location *	WS
Category	Earthen Levee			GPS Latitude/Longitude	
				Start	End
Item	Vegetation			37.258975 °	37.258036 °
				-120.826389 °	-120.823149 °
DWR ID	DWR_NA0010_01_s_2022_138				
Comment Code					
V1 : Control annual grass and weeds on the levee slopes and easements.					
Inspector Comment

View of the waterside slope looking upstream. (Spring 2022)

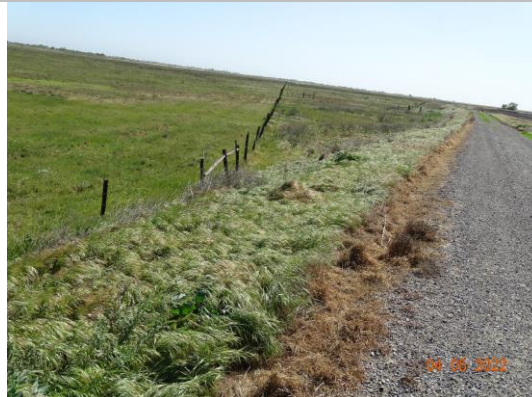
Photo 1 of 1 : SP_2022_NA0010_118_137_20220412_00310.jpg

LM Start	12.62	Rating **	M	Issue No.	137
LM End	13.97	Issue Type +	Ma	Location *	LS
Category	Earthen Levee			GPS Latitude/Longitude	
				Start	End
Item	Vegetation			37.258975 °	37.245727 °
				-120.826389 °	-120.818247 °
DWR ID	DWR_NA0010_01_s_2022_137				
Comment Code					
V1 : Control annual grass and weeds on the levee slopes and easements.					
Inspector Comment

Looking at vegetation on the landside slope. (Spring 2022)

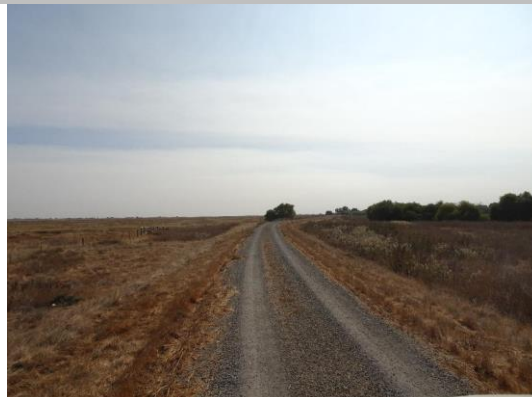
Photo 1 of 3 : UCIP_SP_2022_70690_92843.jpg

Comment Code						
Inspector Comment						
FS_ID:70690 DS_ID:19637 EP_NO: N/A Repair Type: Non-Urgent Crossing Status: Found UCIP Comments: 10/21/2020 Record remains Non-Urgent. DWR DMP has found integrity issues, LOF between 4 and 5. Crossing will be monitored until funding becomes available for rehabilitation. Proper inspection inhibited by dense vegetation. Recommend vegetation removal along pipe alignment. No permit was found authorizing this encroachment. CVFPB will need to review crossing to determine owner. (B. Singh - GEI, O. Magana - DWR UCIP)04/25/2014 Concrete headwall on landward side blocked by debris. Dense vegetation limits the inspector's visibility to identify signs of pipe failure (leaks) along the landward slope. Recommend removing vegetation along pipe alignment to conduct proper inspection of crossing. (O. Magana - DWR UCIP) FIELD_STRUCT_DESC: 24-inch corrugated metal (CM) gravity drainage pipe through the levee, 9.5 feet below the crown. Flap gate on the waterside (WS) end. Brass cap No. 60 bench mark (BM) on the headwall on the landside (LS). [Additional Reference(s): DWR Levee Log, 2002, (HLM 12.95). USACE San Joaquin O&M Manual, Unit No. 601, Part No. 1, (SJR601.1), 1967, Revised 25 May 2011, (HLM 12.94)]. FS Date: 10/21/2020

Overview of levee crown looking upstream towards pipe crossing past curve.

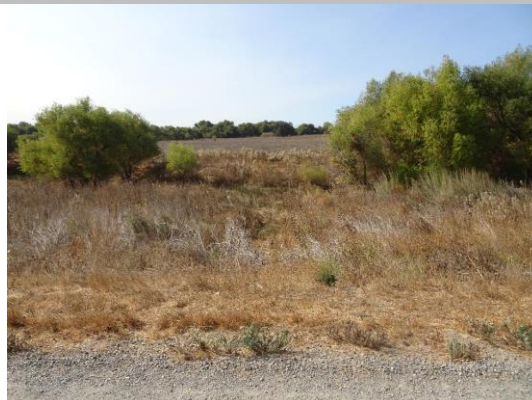
Photo 2 of 3 : UCIP_SP_2022_70690_90965.jpg

WS view: overview of WS

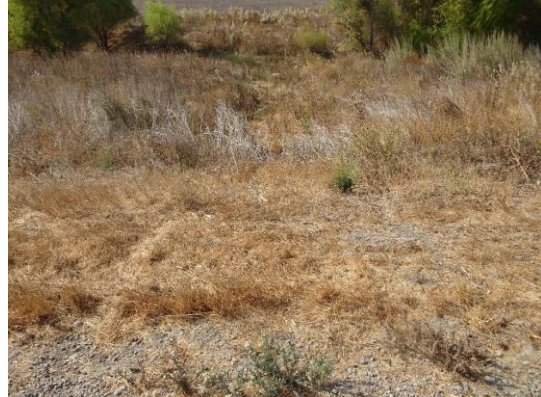
Photo 3 of 3 : UCIP_SP_2022_70690_90966.jpg

WS view: dense vegetation along WS toe. Pipe and flap gate visible on WS toe.

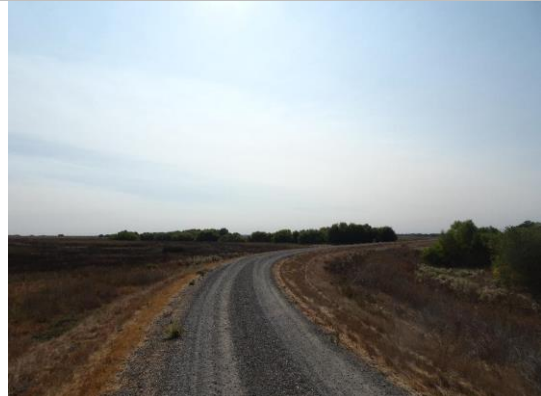
Photo 1 of 3 : UCIP_SP_2022_70691_92844.jpg

FS_ID:70691
 DS_ID:19638
 EP_NO: N/A
 Repair Type: Non-Urgent
 Crossing Status: Found
 UCIP Comments: 10/21/2020 Record remains Non-Urgent. No permit was found authorizing this encroachment. CVFPB will need to review crossing to determine owner. DWR DMP internal inspection is pending and scheduled for 2021. (B. Singh - GEI, O. Magana - DWR UCIP)04/25/2014 Dense vegetation limits the inspector's visibility to identify signs of pipe failure (leaks) along the landward slope. Concrete headwall blocked by debris located on landward toe. Recommend clearing debris from landward slope and toe. (O. Magana - DWR UCIP)
 FIELD_STRUCT_DESC: 24-inch corrugated metal (CM) gravity drainage pipe through the levee, 14.2 feet below the crown. Flap gate on the waterside (WS) end. Brass cap No. 60 bench mark (BM) on the headwall on the landside (LS). [Additional Reference(s): DWR Levee Log, 2002, (HLM 13.48). USACE San Joaquin O&M Manual, Unit No. 601, Part No. 1, (SJR601.1), 1967, Revised 25 May 2011, (HLM 13.48)].

Overview of levee looking upstream towards pipe.

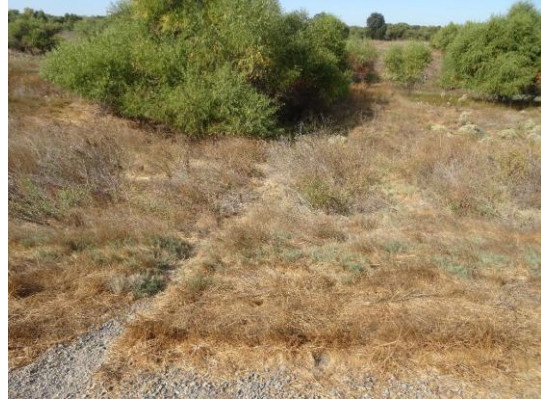
Photo 2 of 3 : UCIP_SP_2022_70691_90967.jpg

WS view: overview of WS

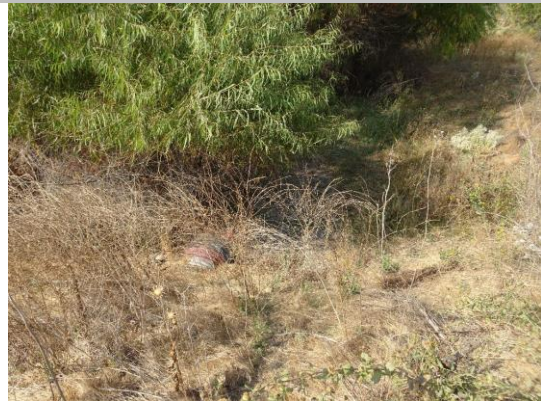
Photo 3 of 3 : UCIP_SP_2022_70691_90969.jpg

WS view: pipe and flapgate visible at WS toe

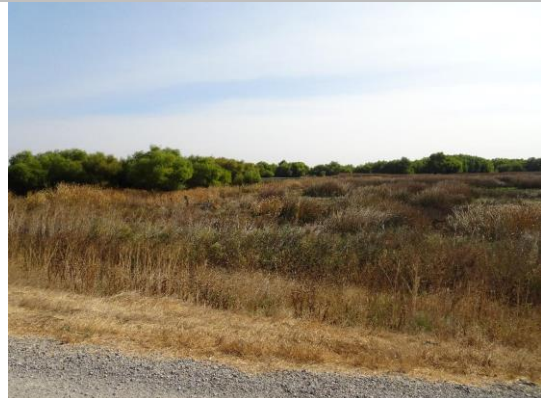
Photo 2 of 3 : UCIP_SP_2022_70692_90973.jpg

LS view: overview of LS. No headwall found through dense vegetation.

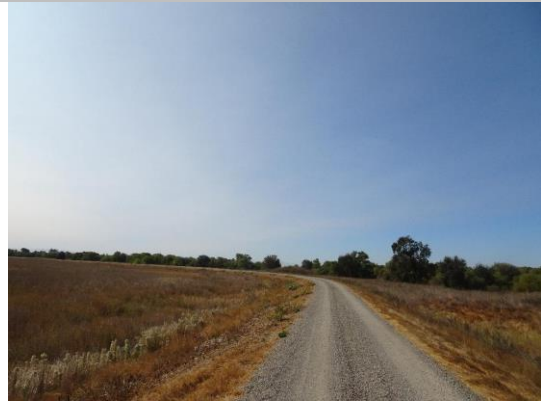
Photo 1 of 3 : UCIP_SP_2022_70693_90976.jpg

FS_ID:70693
DS_ID:19640
EP_NO: N/A
Repair Type: Non-Urgent
Crossing Status: Indicator Found
UCIP Comments: 10/21/2020 Record remains Non-Urgent. No permit was found authorizing this encroachment. CVFPB will need to review crossing to determine owner. DWR DMP has not found internal issues, LOF between 1 and 2. Recommend inspection in 5 years. (B. Singh - GEI, O. Magana - DWR UCIP)04/25/2014 No photos available-- missed crossing. Aerial photograph indicates crossing is present. Need to confirm if crossing is still present on waterward side. (O. Magana - DWR UCIP)
FIELD_STRUCT_DESC: 24-inch corrugated metal (CM) gravity drainage pipe through the levee, 11.0 feet below the crown. Flap gate on the waterside (WS) end. Brass cap No. 60 bench mark (BM) on the headwall on the landside (LS). [Additional Reference(s): DWR Levee Log, 2002, (HLM 13.83). USACE San Joaquin O&M Manual, Unit No. 601, Part No. 1, (SJR601.1), 1967, Revised 25 May 2011, (HLM 13.81)].

Overview of levee crown looking upstream towards crossing, photo 1 of 2.

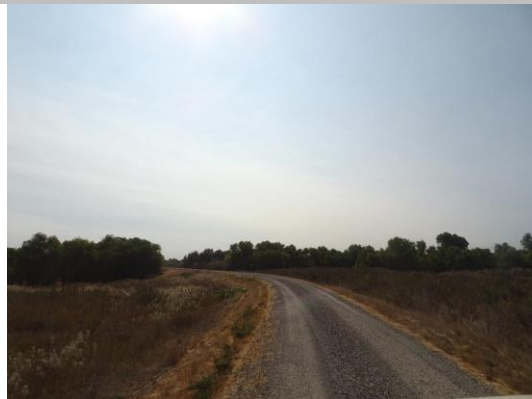
Photo 2 of 3 : UCIP_SP_2022_70693_92858.jpg

Overview of levee crown looking upstream towards crossing, photo 2 of 2.

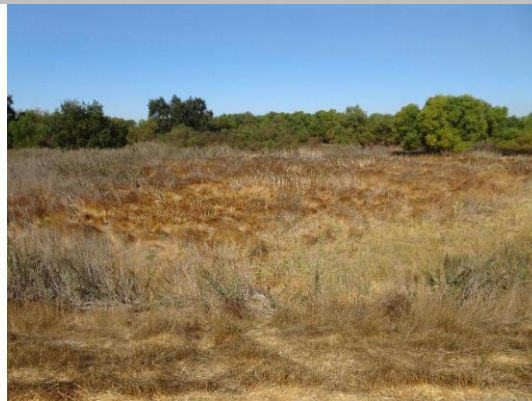
Photo 3 of 3 : UCIP_SP_2022_70693_90978.jpg

WS view: overview of WS. Pipe and flapgate visible at WS toe

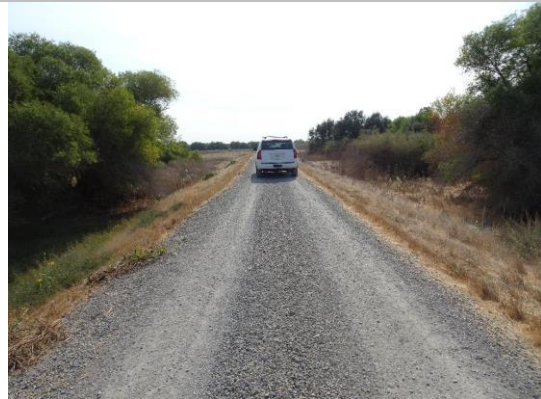
Photo 1 of 3 : UCIP_SP_2022_70694_90986.jpg

Comment Code					
Inspector Comment					
FS_ID:70694 DS_ID:19641 EP_NO: N/A Repair Type: Non-Urgent Crossing Status: Found UCIP Comments: 10/21/2020 Record remains Non-Urgent. Dense vegetation at LS and WS toes inhibited proper inspection. No permit was found authorizing this encroachment. CVFPB will need to review crossing to determine owner. DWR DMP has not found internal issues, LOF between 1 and 2. Recommend inspection in 5 years. (B. Singh - GEI, O. Magana - DWR UCIP)04/25/2014 Dense vegetation limits the inspector's visibility to identify signs of pipe failure (leaks) along the slopes. Recommend removing vegetation along pipe alignment to conduct proper inspection of structure. (O. Magana - DWR UCIP) FIELD_STRUCT_DESC: 24-inch corrugated metal (CM) gravity drainage pipe through the levee, 13.0 feet below the crown. Flap gate on the waterside (WS) end. Brass cap No. 60 bench mark (BM) on the headwall on the landside (LS). [Additional Reference(s): DWR Levee Log, 2002, (HLM 14.22). USACE San Joaquin O&M Manual, Unit No. 601, Part No. 1, (SJR601.1), 1967, Revised 25 May 2011, (HLM 14.21)]. FS Date: 10/21/2020

Overview of levee crown looking upstream towards pipe crossing.

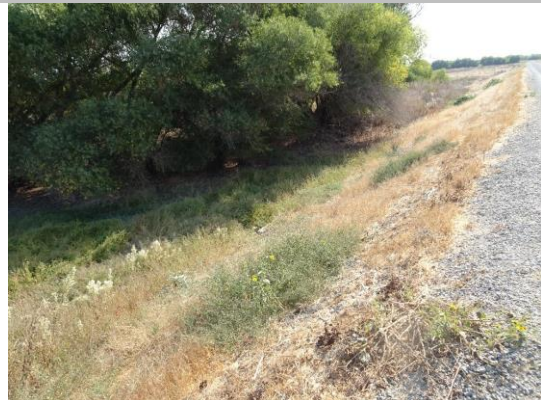
Photo 2 of 3 : UCIP_SP_2022_70694_90988.jpg

LS view: overview of LS

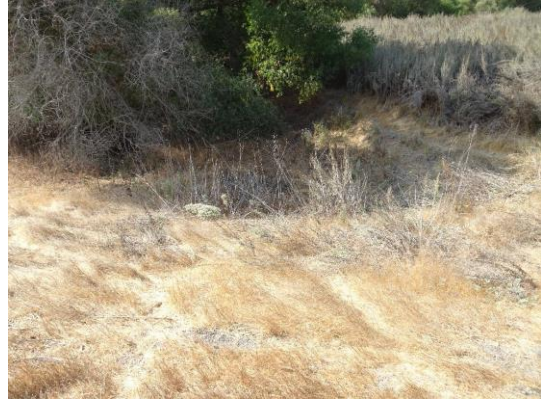
Photo 3 of 3 : UCIP_SP_2022_70694_90990.jpg

WS view: overview of WS

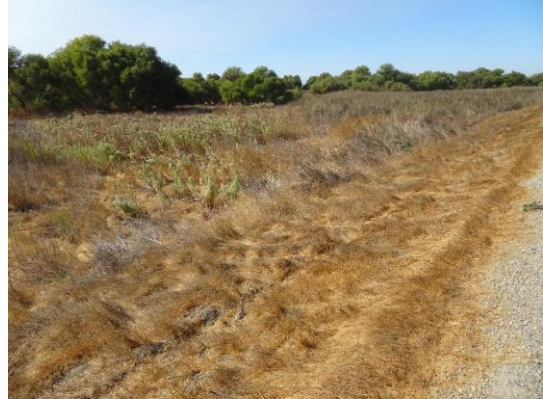
Photo 2 of 3 : UCIP_SP_2022_70695_90993.jpg

WS view: WS slope profile looking downstream

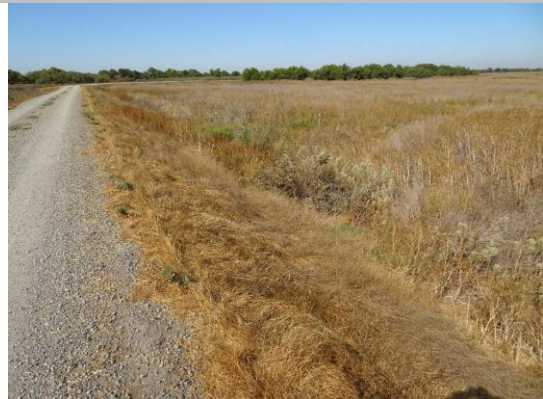
Photo 3 of 3 : UCIP_SP_2022_70695_90994.jpg

LS view: LS slope profile looking downstream

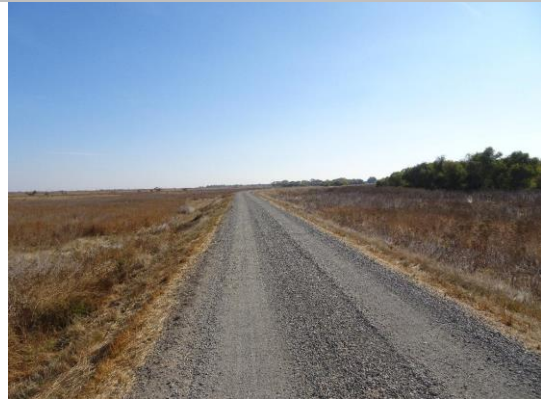
Photo 1 of 3 : UCIP_SP_2022_70696_90792.jpg

FS_ID:70696
DS_ID:19643
EP_NO: N/A
Repair Type: Non-Urgent
Crossing Status: Found
UCIP Comments: 11/16/2020 Record remains Non-Urgent. Dense vegetation on LS toe limited inspection of pipe. Significant burrowing observed on LS and WS slopes. Recommend vegetation removal and rodent mitigation. No permit was found authorizing this encroachment. CVFPB will need to review crossing to determine owner. DWR DMP has not found internal issues, LOF between 1 and 2. Recommend inspection in 5 years. (B. Singh - GEI, O. Magana - DWR UCIP)04/25/2014 Dense vegetation limits the inspector's visibility to identify signs of pipe failure (leaks) along the landward slope. Recommend removing vegetation along pipe alignment to conduct proper inspection of structure. (O. Magana - DWR UCIP)
FIELD_STRUCT_DESC: 24-inch corrugated metal (CM) gravity drainage pipe through the levee, 9.2 feet below the crown. Flap gate on the waterside (WS) end. Brass cap No. 60 bench mark (BM) on the headwall on the landside (LS). [Additional Reference(s): DWR Levee Log, 2002, (HLM 15.31). USACE San Joaquin O&M Manual, Unit No. 601, Part No. 1, (SJR601.1), 1967, Revised 25 May 2011, (HLM 15.29)].

Overview of levee crown, looking US

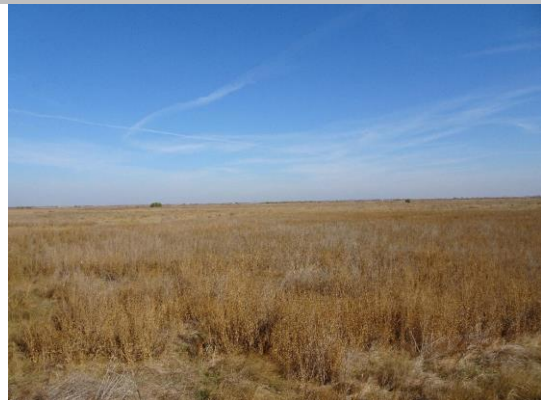
Photo 2 of 3 : UCIP_SP_2022_70696_92869.jpg

LS view: overview of LS.

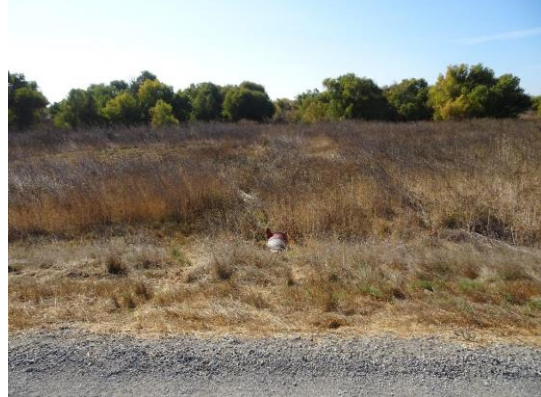
Photo 3 of 3 : UCIP_SP_2022_70696_90793.jpg

WS view: overview of WS. Pipe and flapgate visible on WS toe.

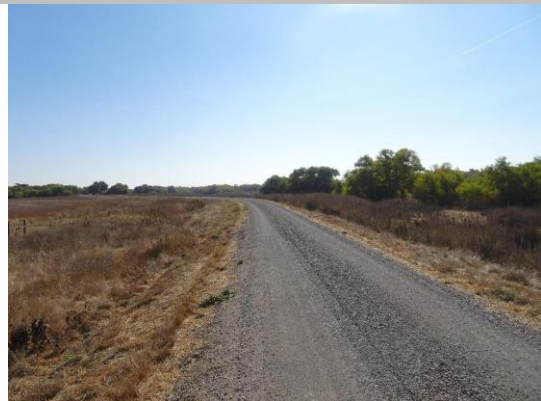
Photo 1 of 3 : UCIP_SP_2022_70697_90797.jpg

FS_ID:70697
DS_ID:19644
EP_NO: N/A
Repair Type: Non-Urgent
Crossing Status: Found
UCIP Comments: 11/16/2020 Recor remains Non-Urgent. Dense vegetation on LS toe and slope inhibited proper inspection of pipe. No permit was found authorizing this encroachment. CVFPB will need to review crossing to determine owner. DWR DMP has not found internal issues, LOF between 1 and 2. Recommend inspection in 5 years. (O. Magana - DWR UCIP, B. Singh - GEI)04/25/2014 Dense vegetation limits the inspector's visibility to identify signs of pipe failure (leaks) along the waterward and landward slopes. Recommend removing vegetation along pipe alignment to conduct proper inspection of structure. (O. Magana - DWR UCIP)
FIELD_STRUCT_DESC: 24-inch corrugated metal (CM) gravity drainage pipe through the levee, 8.5 feet below the crown. Flap gate on the waterside (WS) end. Brass cap No. 60 bench mark (BM) on the headwall on the landside (LS). [Additional Reference(s): DWR Levee Log, 2002, (HLM 15.57). USACE San Joaquin O&M Manual, Unit No. 601, Part No. 1, (SJR601.1), 1967, Revised 25 May 2011, (HLM 15.57)].

Overview of levee crown, looking US

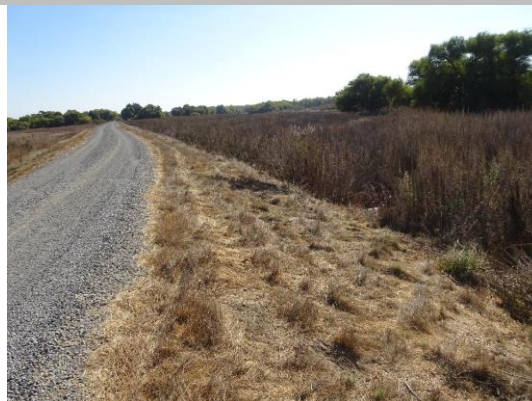
Photo 3 of 3 : UCIP_SP_2022_70697_92963.jpg

WS view: profile of WS slope.

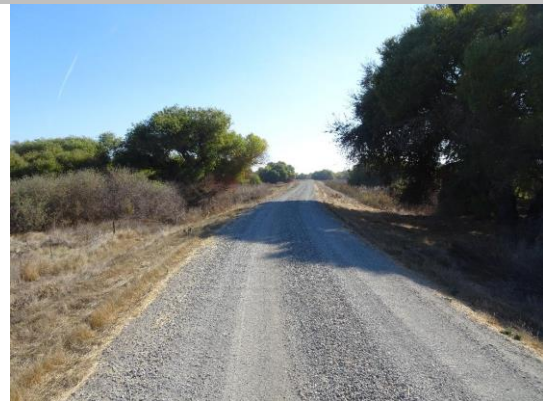
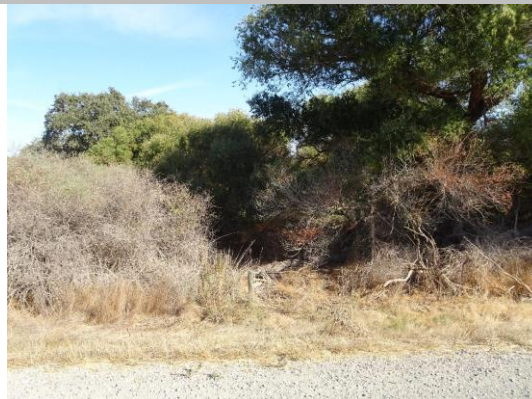
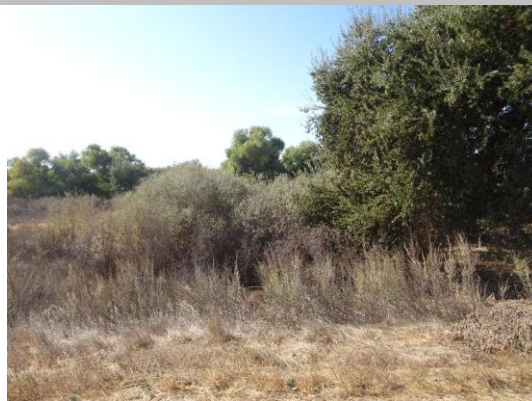
Comment Code						
Inspector Comment						
FS_ID:70698 DS_ID:19645 EP_NO: N/A Repair Type: Non-Urgent Crossing Status: Found UCIP Comments: 11/16/2020 Record remains Non-Urgent. Corrosion observed in pipe inlet on the LS toe. Recommend internal inspection of the pipe through the levee to determine extent of damage. Some burrowing activity found on both LS and WS slope. No permit was found authorizing this encroachment. CVFPB will need to review crossing to determine owner. DWR DMP internal inspection is pending and scheduled for 2021. (B. Singh - GEI, O. Magana - DWR UCIP)04/25/2014 Dense vegetation limits the inspector's visibility to identify signs of pipe failure (leaks) along the waterward and landward slope. Recommend removing vegetation along pipe alignment to conduct proper inspection of structure. (O. Magana - DWR UCIP) FIELD_STRUCT_DESC: 24-inch corrugated metal (CM) gravity drainage pipe through the levee, 11.0 feet below the crown. Flap gate on the waterside (WS) end. Brass cap No. 60 bench mark (BM) on the headwall on the landside (LS). [Additional Reference(s): DWR Levee Log, 2002, (HLM 15.82). USACE San Joaquin O&M Manual, Unit No. 601, Part No. 1, (SJR601.1), 1967, Revised 25 May 2011, (HLM 15.81)]. FS Date: 11/16/2020

Overview of levee crown, looking US

LS view: overview of LS

WS view: overview of WS

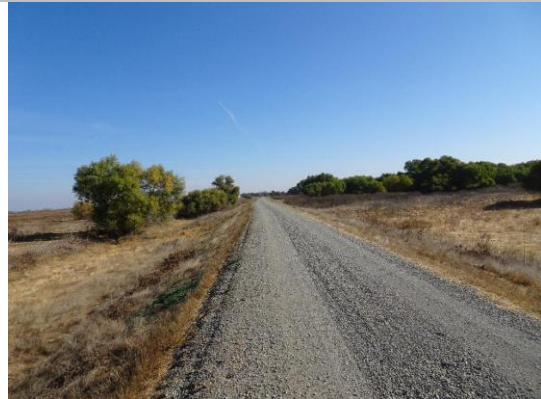
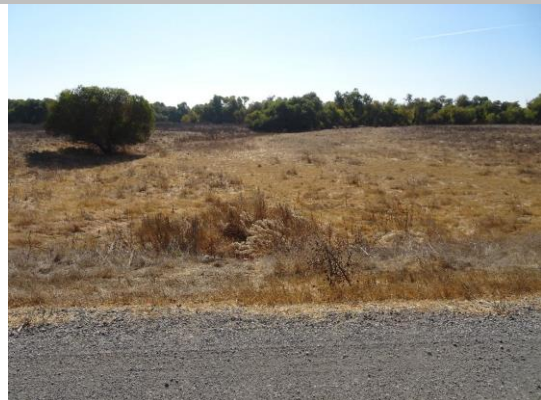
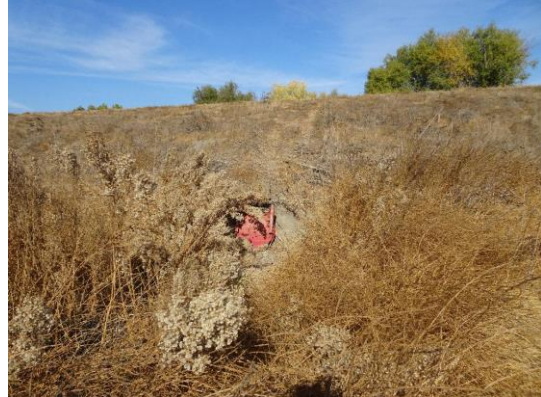
Comment Code						
Inspector Comment						
FS_ID:70699 DS_ID:19646 EP_NO: N/A Repair Type: Urgent Crossing Status: Found UCIP Comments: 11/16/2020 Record has been updated from Non-Urgent to Urgent. DWR DMP has found integrity issues, LOF between 5 and 6. Crossing will be monitored until funding becomes available to address. Burrowing activity observed on LS and WS slopes. No permit was found authorizing this encroachment. CVFPB will need to review crossing to determine owner. (B. Singh - GEI, O. Magana - DWR UCIP)04/25/2014 Dense vegetation limits the inspector's visibility to identify signs of pipe failure (leaks) along the waterward and landward slopes. Recommend removing vegetation along pipe alignment to conduct proper inspection of structure and appurtenances. (O. Magana - DWR UCIP) FIELD_STRUCT_DESC: 24-inch corrugated metal (CM) gravity drainage pipe through the levee, 11.3 feet below the crown. Flap gate on the waterside (WS) end. Brass cap No. 50 bench mark (BM) on the headwall on the landside (LS). [Additional Reference(s): DWR Levee Log, 2002, (HLM 16.09). USACE San Joaquin O&M Manual, Unit No. 601, Part No. 1, (SJR601.1), 1967, Revised 25 May 2011, (HLM 16.09)]. FS Date: 11/16/2020

Overview of levee looking upstream towards crossing.

WS view: overview of WS.

WS view: concrete wingwall and pipe with flap gate visible on WS toe.

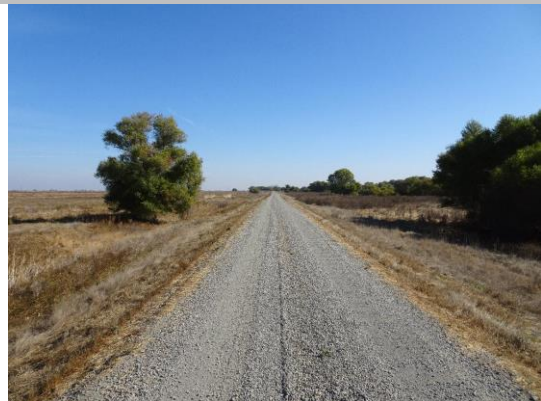
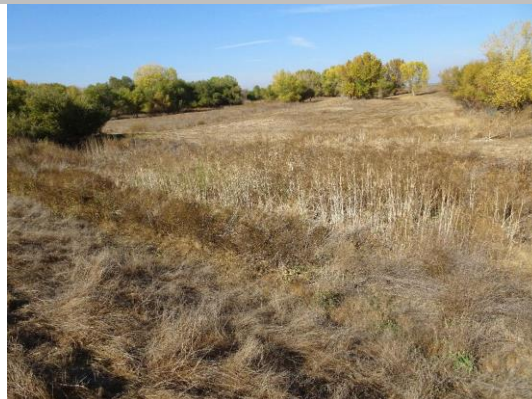
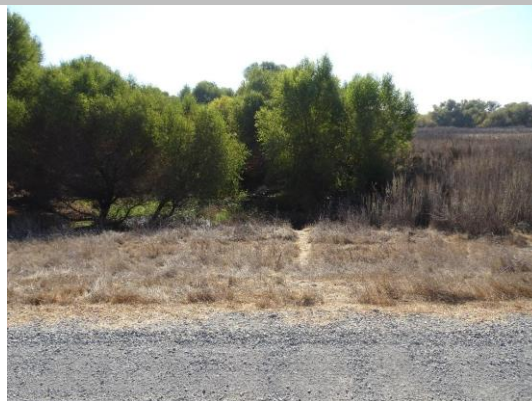
FS_ID:70700
DS_ID:19647
EP_NO: N/A
Repair Type: Non-Urgent
Crossing Status: Found
UCIP Comments: 11/16/2020 Record remains Non-Urgent. Pipe and flapgate on WS toe were under water and there is dense vegetation on the LS slope and toe, inhibiting inspection. No permit was found authorizing this encroachment. CVFPB will need to review crossing to determine owner. DWR DMP internal inspection status is pending. Contacted A. Asrate with DMP staff to find out internal inspection results from 2020. (B. Singh - GEI, O. Magana - DWR UCIP)04/25/2014 Dense vegetation limits the inspector's visibility to identify signs of pipe failure (leaks) along the waterward and landward slopes. Recommend removing vegetation along pipe alignment to conduct proper inspection of structure. Unable to find pipe on landward side. (O. Magana - DWR UCIP)
FIELD_STRUCT_DESC: 24-inch corrugated metal (CM) gravity drainage pipe through the levee, 14.7 feet below the crown. Flap gate on the waterside (WS) end. Brass cap No. 50 bench mark (BM) on the headwall on the landside (LS). [Additional Reference(s): DWR Levee Log, 2002, (HLM 16.16). USACE San Joaquin O&M Manual, Unit No. 601, Part No. 1, (SJR601.1), 1967, Revised 25 May 2011, (HLM 16.15)].

Overview of levee crown looking upstream towards pipe crossing.

LS view: overview of LS.

WS view: overview of WS.

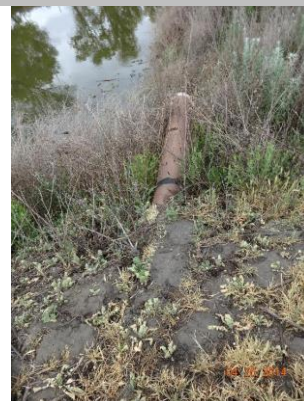
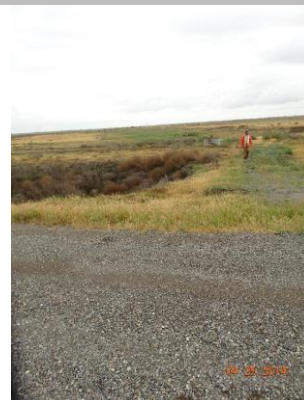
LM Start	16.72	Rating **	M	Issue No.	74	
LM End	16.72	Issue Type +	En	Location *		
Category	Supplemental			GPS Latitude/Longitude		
				Start		End
Item	DWR UCIP Field Study			37.224223 °		37.224223 °
				-120.783806 °		-120.783806 °
DWR ID	24870					
Comment Code						
Inspector Comment						
FS_ID:70702 DS_ID:24870 EP_NO: N/A Repair Type: Non-Urgent Crossing Status: Found UCIP Comments: 11/16/2020 Record remains Non-Urgent. No permit has been found authorizing this pipe. CVFPB will need to review crossing to determine owner. (O. Magana - DWR UCIP)04/25/2014 Need to contact owner to determine status and reason for crossing. (O. Magana - DWR UCIP) FIELD_STRUCT_DESC: 12-inch steel gravity drainage pipe through the levee, at an unknown depth. Concrete standpipe on the landside (LS). This pipe was field discovered. FS Date: 11/6/2020

View of pipe located on waterward side.

View of landward side.

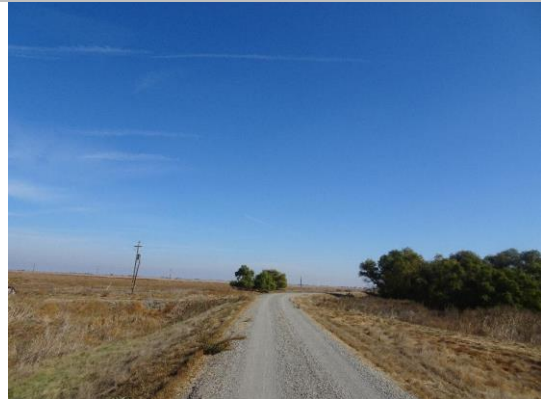
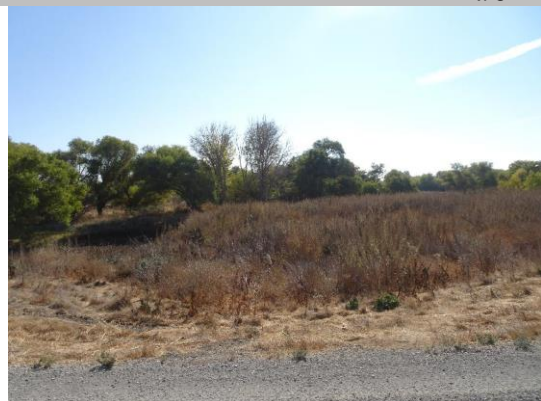
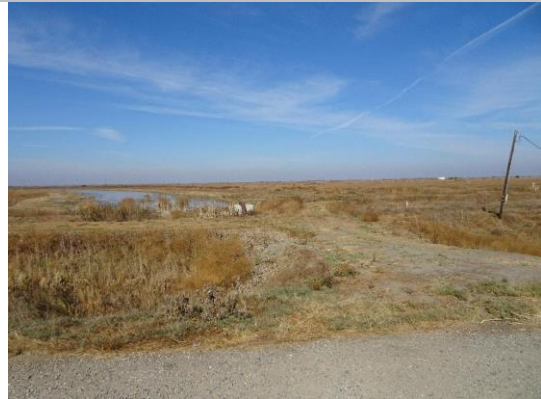
Comment Code						
Inspector Comment						
FS_ID:70701 DS_ID:19649 EP_NO: 13549 Repair Type: Non-Urgent Crossing Status: Not Found UCIP Comments: 11/16/2020 Record remains Non-Urgent. Gravity drainage pipe through the levee, 2 feet below the crown, was measured at 12 inches instead of 30 inches pipe. Pump and concrete standpipe at the center of the levee were not found, and a siphon breaker was not found on the LS shoulder. Recommend a detail review of permit and record files to determine what was constructed at this location and the alignment of the pipe. Need to contact owner to obtain permit authorizing modifications to previously approved 30-inch pipe. (B. Singh - GEI, O. Magana - DWR UCIP) FIELD_STRUCT_DESC: 30-inch coated steel irrigation discharge pipe through the levee, 2.0 feet below the crown. Steel cutoff walls around the pipe at the center of the levee. Siphon breaker on the apex of the pipe on the landside (LS) shoulder. Pump and concrete standpipe on the waterside (WS). Pipe extends to existing irrigation ditch off the LS toe. (Concrete irrigation pipe stand, 60-horsepower [hp] pump, 30-inch steel pipe, and enlarged diversion channel from the river to the pump intake authorized under Permit No. 13549, 1983 - Joseph E. Gallo). [Additional Reference(s): DWR Levee Log, 2002, (HLM 16.73)]. FS Date: 11/16/2020

Overview of levee crown, looking US

WS view: overview of WS. Pipe not found at WS toe and dense vegetation.

LS view: overview of LS. Concrete cone with 12" pipe found.

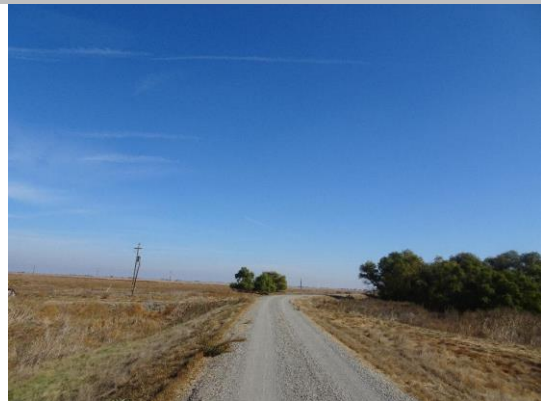
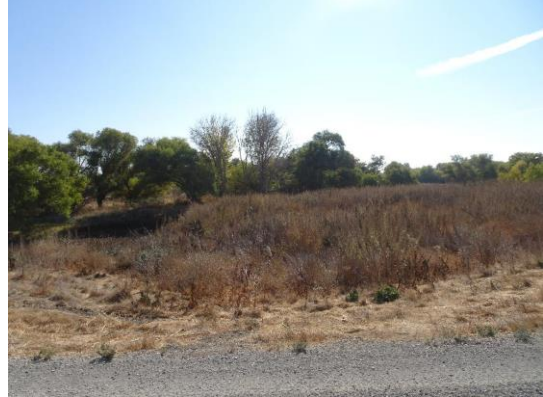
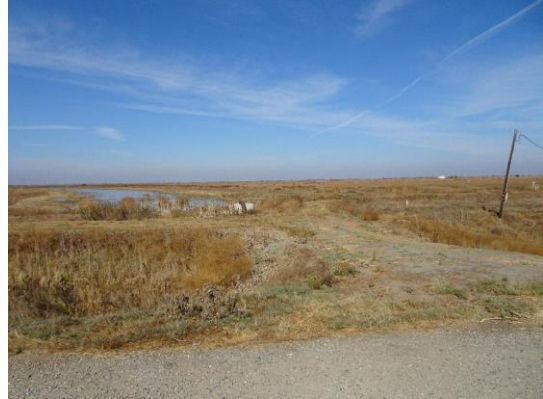
FS_ID:70703
 DS_ID:19648
 EP_NO: N/A
 Repair Type: Non-Urgent
 Crossing Status: Found
 UCIP Comments: 11/16/2020 Record remains Non-Urgent. Unable to locate pipe on both LS and WS toes due to dense vegetation. Recommend vegetation removal for proper inspections. DWR DMP internal inspection is pending and scheduled for 2021. No permit was found authorizing this encroachment. CVFPB will need to review crossing to determine owner. (B. Singh - GEI, O. Magana - DWR UCIP)04/25/2014 Dense vegetation limits the inspector's visibility to identify signs of pipe failure (leaks) along the waterward and landward slopes. Recommend removing vegetation along pipe alignment to conduct proper inspection of structure. Unable to find pipe on landward side. (O. Magana - DWR UCIP)
 FIELD_STRUCT_DESC: 24-inch corrugated metal (CM) gravity drainage pipe through the levee, 11.4 feet below the crown. Flap gate on the waterside (WS) end. Brass cap No. 50 bench mark (BM) on the headwall on the landside (LS). [Additional Reference(s): DWR Levee Log, 2002, (HLM 16.73). USACE San Joaquin O&M Manual, Unit No. 601, Part No. 1, (SJR601.1), 1967, Revised 25 May 2011, (HLM 16.72)].

Overview of levee crown, looking US

WS view: overview of WS. Pipe and flapgate not found; dense vegetation.

LS view: overview of LS.

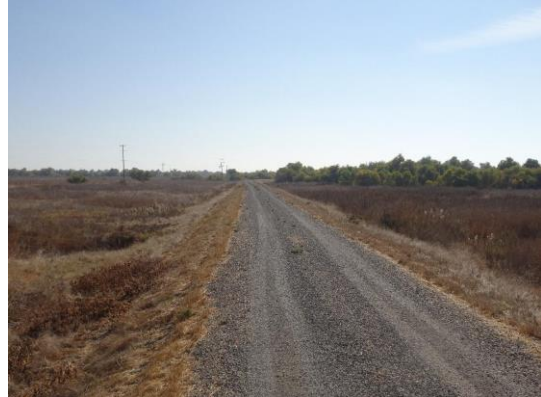
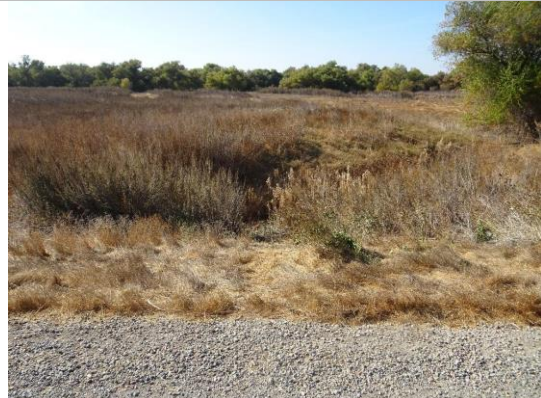
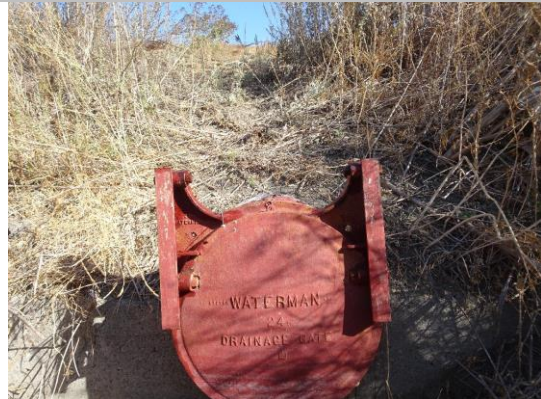
Comment Code						
Inspector Comment						
FS_ID:70704 DS_ID:19577 EP_NO: N/A Repair Type: Non-Urgent Crossing Status: Found UCIP Comments: 11/16/2020 Record remains Non-Urgent. No permit was found authorizing this encroachment. CVFPB will need to review crossing to determine owner. DWR DMP has not found internal issues, LOF between 1 and 2. Recommend inspection in 5 years. (B. Singh - GEI, O. Magana - DWR UCIP)04/25/2014 Dense vegetation limits the inspector's visibility to identify signs of pipe failure (leaks) along the waterward and landward slopes. Concrete headwall is buried by dense vegetation. Recommend removing vegetation along pipe alignment to conduct proper inspection of structure. (O. Magana - DWR UCIP) FIELD_STRUCT_DESC: 24-inch corrugated metal (CM) gravity drainage pipe through the levee, 11.5 feet below the crown. Flap gate on the waterside (WS) end. Brass cap No. 50 bench mark (BM) on the headwall on the landside (LS). [Additional Reference(s): DWR Levee Log, 2002, (HLM 17.01). USACE San Joaquin O&M Manual, Unit No. 601, Part No. 1, (SJR601.1), 1967, Revised 25 May 2011, (HLM 17.01)]. FS Date: 11/16/2020

Overview of levee crown, looking US

WS view: overview of WS.

WS view: pipe and flap gate visible on WS toe.

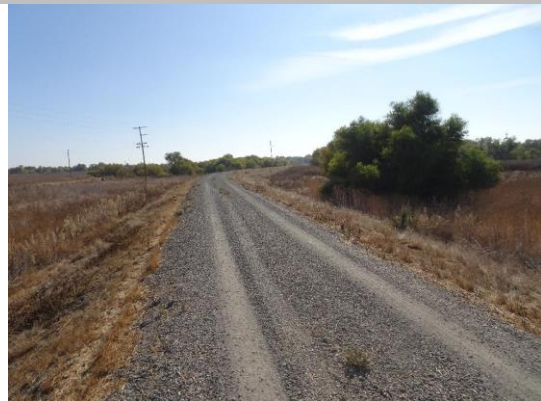
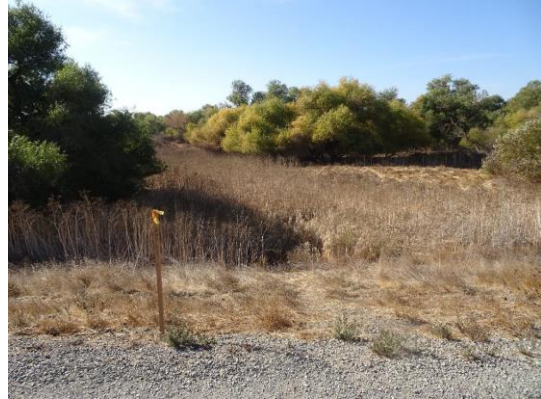
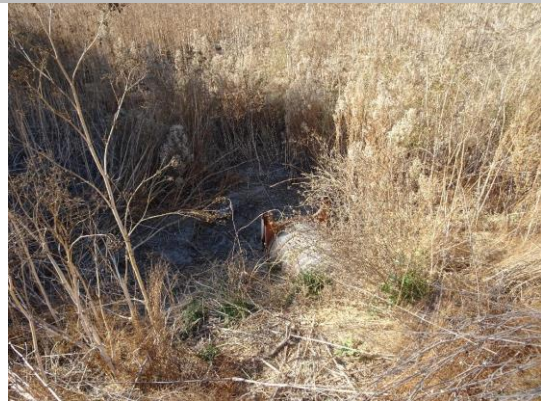
FS_ID:70705
DS_ID:19578
EP_NO: N/A
Repair Type: Non-Urgent
Crossing Status: Found
UCIP Comments: 11/16/2020 Record remains Non-Urgent. No permit was found authorizing this encroachment. CVFPB will need to review crossing to determine owner. DWR DMP has not found internal issues, LOF between 1 and 2. Recommend inspection in 5 years. (B. Singh - GEI, O. Magana - DWR UCIP)04/25/2014 Dense vegetation limits the inspector's visibility to identify signs of pipe failure (leaks) along the waterward and landward slopes. Recommend removing vegetation along pipe alignment to conduct proper inspection of structure. Sediment buildup inside pipe visible from landward side. Recommend clearing pipe. (O. Magana - DWR UCIP)
FIELD_STRUCT_DESC: 24-inch corrugated metal (CM) gravity drainage pipe through the levee, 11.5 feet below the crown. Flap gate on the waterside (WS) end. Brass cap No. 50 bench mark (BM) on the headwall on the landside (LS). [Additional Reference(s): DWR Levee Log, 2002, (HLM 17.20). USACE San Joaquin O&M Manual, Unit No. 601, Part No. 1, (SJR601.1), 1967, Revised 25 May 2011, (HLM 17.19)].

Overview of levee crown looking upstream towards pipe crossing.

WS view: overview of WS.

WS view: pipe outlet visible on WS toe.

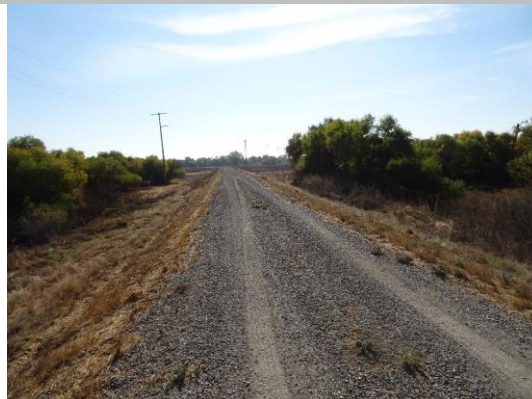
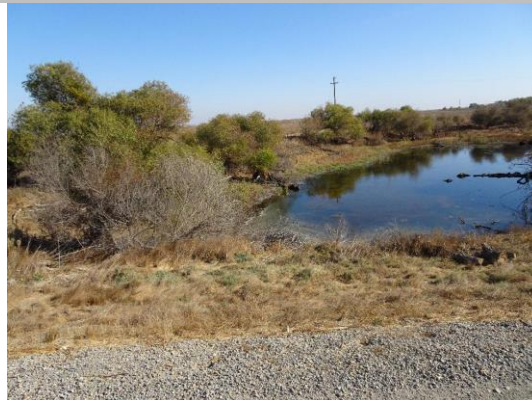
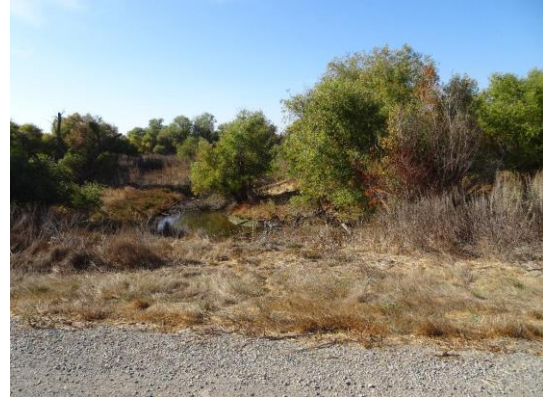
Comment Code					
Inspector Comment					
FS_ID:70706 DS_ID:19579 EP_NO: N/A Repair Type: Non-Urgent Crossing Status: Found UCIP Comments: 11/16/2020 Record remains Non-Urgent. Debris is blocking flapgate on the WS inlet. No permit was found authorizing this encroachment. CVFPB will need to review crossing to determine owner. DWR DMP internal inspection is pending and scheduled for 2021. (B. Singh - GEI, O. Magana - DWR UCIP)04/25/2014 Dense vegetation limits the inspector's visibility to identify signs of pipe failure (leaks) along the waterward and landward slope. Recommend removing vegetation along pipe alignment to conduct proper inspection of structure. (O. Magana - DWR UCIP) FIELD_STRUCT_DESC: 24-inch corrugated metal (CM) gravity drainage pipe through the levee, 15.8 feet below the crown. Flap gate on the waterside (WS) end. Brass cap No. 50 bench mark (BM) on the headwall on the landside (LS). [Additional Reference(s): DWR Levee Log, 2002, (HLM 17.27). USACE San Joaquin O&M Manual, Unit No. 601, Part No. 1, (SJR601.1), 1967, Revised 25 May 2011, (HLM 17.26)]. FS Date: 11/16/2020

Overview of levee crown looking upstream towards crossing.

LS view: overview of LS

WS view: overview of WS, photo 1 of 2.

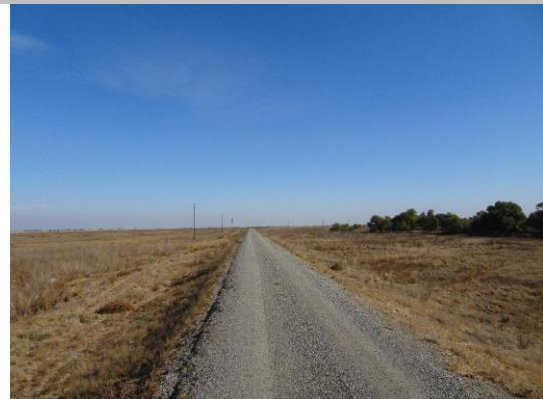
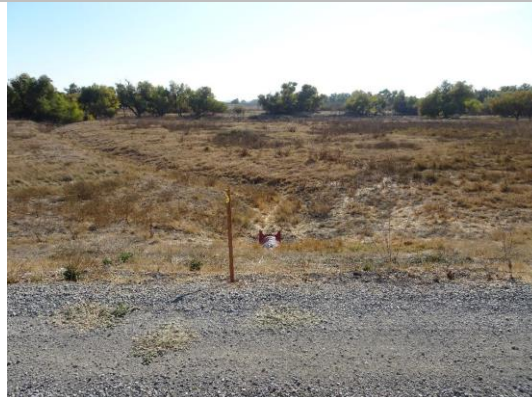
FS_ID:70707
 DS_ID:19580
 EP_NO: N/A
 Repair Type: Urgent
 Crossing Status: Found
 UCIP Comments: 11/16/2020 Record has been updated from Non-Urgent to Urgent. Pipe in failed condition on the LS. Potential sink hole located about 1 foot from the LS toe. No permit was found authorizing this encroachment. CVFPB will need to review crossing to determine owner. DWR DMP internal inspection is pending and scheduled for 2021. (B. Singh - GEI, O. Magana - DWR UCIP)04/25/2014 Dense vegetation limits the inspector's visibility to identify signs of pipe failure (leaks) along the landward slope. Recommend removing vegetation along pipe alignment to conduct proper inspection of structure. (O. Magana - DWR UCIP)
 FIELD_STRUCT_DESC: 24-inch corrugated metal (CM) gravity drainage pipe through the levee, 9.5 feet below the crown. Flap gate on the waterside (WS) end. Brass cap No. 50 bench mark (BM) on the headwall on the landside (LS). [Additional Reference(s): DWR Levee Log, 2002, (HLM 17.53). USACE San Joaquin O&M Manual, Unit No. 601, Part No. 1, (SJR601.1), 1967, Revised 25 May 2011, (HLM 17.53)].

Overview of levee crown, looking US

WS view: overview of WS. Pipe and flapgate visible on WS toe.

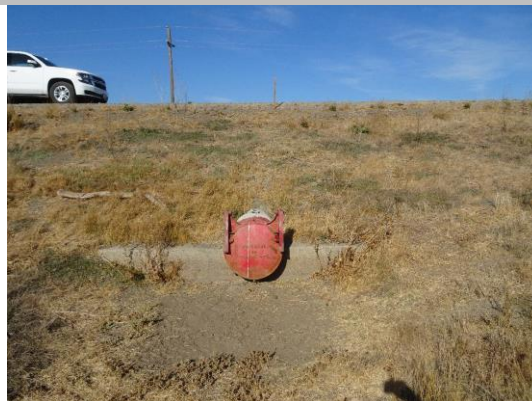
Photo 3 of 3 : UCIP_SP_2022_70707_90842.jpg

WS view: Pipe, headwall, and flapgate at WS toe.

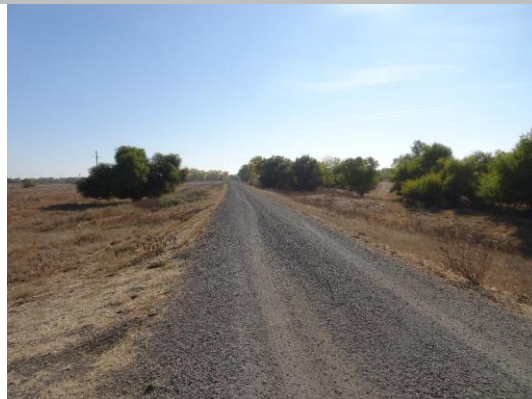
Photo 1 of 3 : UCIP_SP_2022_70708_90849.jpg

Comment Code					
Inspector Comment					
FS_ID:70708 DS_ID:19581 EP_NO: N/A Repair Type: Urgent Crossing Status: Found UCIP Comments: 11/16/2020 Record has been updated from Non-Urgent to Urgent. Considerable damage to the pipe interior is visible from LS toe. DWR DMP has found integrity issues, LOF between 5 and 6. Crossing will be monitored until funding becomes available to address. No permit was found authorizing this encroachment. CVFPB will need to review crossing to determine owner. (B. Singh - GEI, O. Magana - DWR UCIP)04/25/2014 Need to contact owner. Recommend investigating integrity of pipe wall through levee heavy corrosion visible from landward side. (O. Magana - DWR UCIP) FIELD_STRUCT_DESC: 24-inch corrugated metal (CM) gravity drainage pipe through the levee, 11.5 feet below the crown. Flap gate on the waterside (WS) end. Brass cap No. 50 bench mark (BM) on the headwall on the landside (LS). [Additional Reference(s): DWR Levee Log, 2002, (HLM 18.21). USACE San Joaquin O&M Manual, Unit No. 601, Part No. 1, (SJR601.1), 1967, Revised 25 May 2011, (HLM 18.19)]. FS Date: 11/16/2020

Overview of levee crown looking upstream, photo 1 of 2.

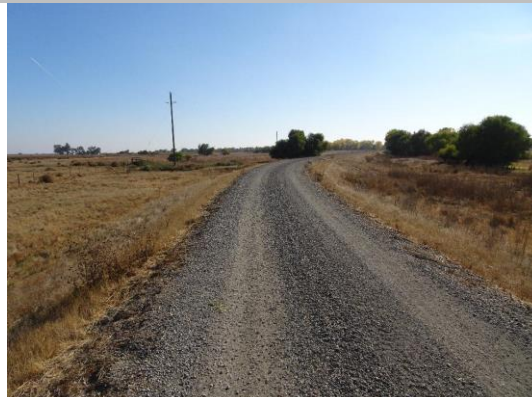
Photo 2 of 3 : UCIP_SP_2022_70708_93033.jpg

Overview of levee crown looking upstream, photo 2 of 2.

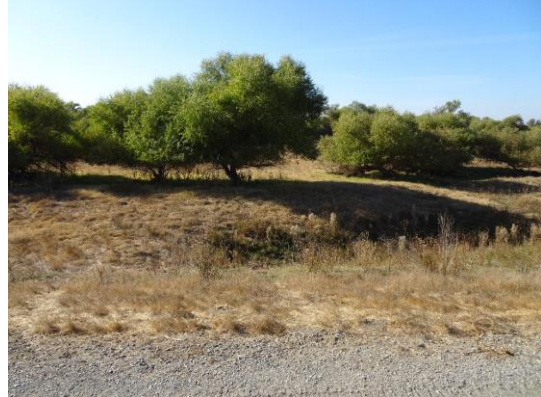
Photo 3 of 3 : UCIP_SP_2022_70708_90852.jpg

WS view: overview of WS.

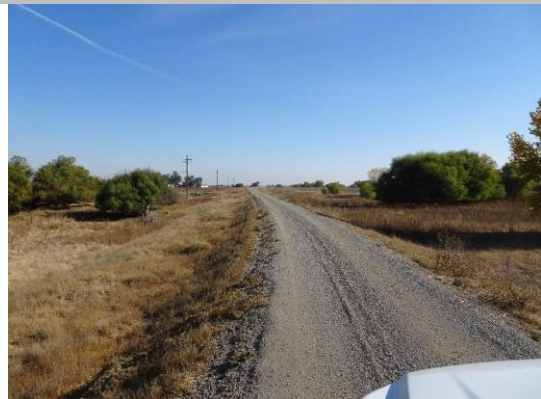
Photo 1 of 3 : UCIP_SP_2022_70709_93037.jpg

FS_ID:70709
 DS_ID:19582
 EP_NO: N/A
 Repair Type: Urgent
 Crossing Status: Found
 UCIP Comments: 11/16/2020 Record has been updated from No Action Needed to Urgent. DWR DMP has found integrity issues, LOF between 5 and 6. No damage observed on the levee during the field inspection. Crossing will be monitored until funding becomes available to address. No permit was found authorizing this encroachment. CVFPB will need to review crossing to determine owner. (B. Singh - GEI, O. Magana - DWR UCIP)
 FIELD_STRUCT_DESC: 24-inch corrugated metal (CM) gravity drainage pipe through the levee, 9.4 feet below the crown. Flap gate on the waterside (WS) end. Brass cap No. 50 bench mark (BM) on the headwall on the landside (LS). [Additional Reference(s): DWR Levee Log, 2002, (HLM 18.47). USACE San Joaquin O&M Manual, Unit No. 601, Part No. 1, (SJR601.1), 1967, Revised 25 May 2011, (HLM 18.45)].
 FS Date: 11/16/2020

Overview of levee crown looking upstream, photo 1 of 2.

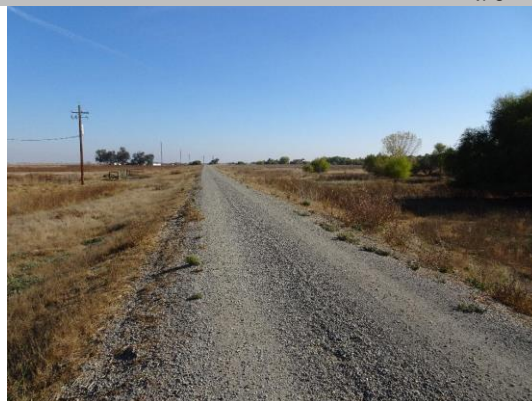
Photo 2 of 3 : UCIP_SP_2022_70709_90856.jpg

Overview of levee crown looking upstream, photo 2 of 2.

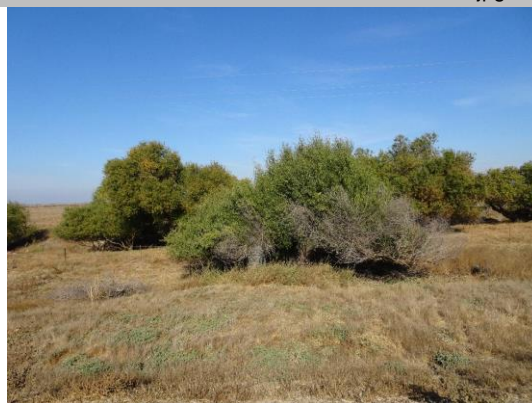
Photo 3 of 3 : UCIP_SP_2022_70709_90854.jpg

LS view: overview of LS.
