**Flood Control Project Maintenance
Levee Inspections
LMA District Cover Sheet**

Lower San Joaquin Levee District

**Flood Control Project Maintenance
Levee Inspections
Unit Cover Sheet**

Levee Inspection Report By Mile - Spring 2022

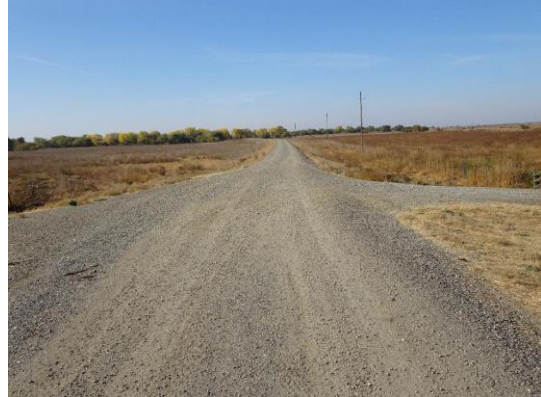
Photo 1 of 3 : UCIP_SP_2022_70711_91059.jpg

FS_ID:70711
DS_ID:19593
EP_NO: N/A
Repair Type: Non-Urgent
Crossing Status: Found
UCIP Comments: 11/16/2020 Record remains Non-Urgent. DWR DMP has found integrity issues, LOF between 4 and 5. Crossing will be monitored until funding becomes available for rehabilitation. No permit was found authorizing this encroachment. CVFPB will need to review crossing to determine owner. Fence located on the WS prevented access to the pipe. (B. Singh - GEI, O. Magana - DWR UCIP)04/25/2014 Dense vegetation limits the inspector's visibility to identify signs of pipe failure (leaks) along the landward slope. Recommend removing vegetation along pipe alignment to conduct proper inspection of structure. (O. Magana - DWR UCIP)
FIELD_STRUCT_DESC: 24-inch corrugated metal (CM) gravity drainage pipe through the levee, 12.0 feet below the crown. Flap gate on the waterside (WS) end. Brass cap No. 50 bench mark (BM) on the headwall on the landside (LS). [Additional Reference(s): DWR Levee Log, 2002, (HLM 18.80). USACE San Joaquin O&M Manual, Unit No. 601, Part No. 1, (SJR601.1), 1967, Revised 25 May 2011, (HLM 18.79)].

Overview of levee crown

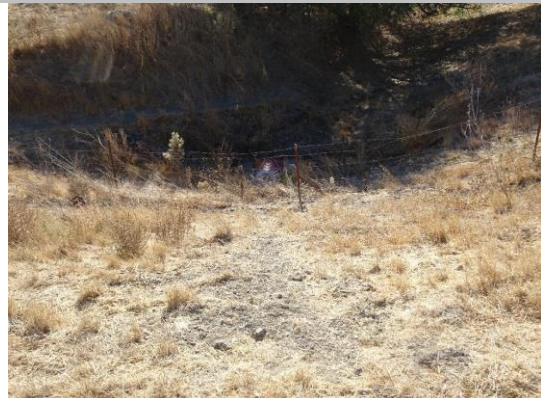
Photo 2 of 3 : UCIP_SP_2022_70711_91061.jpg

View waterward

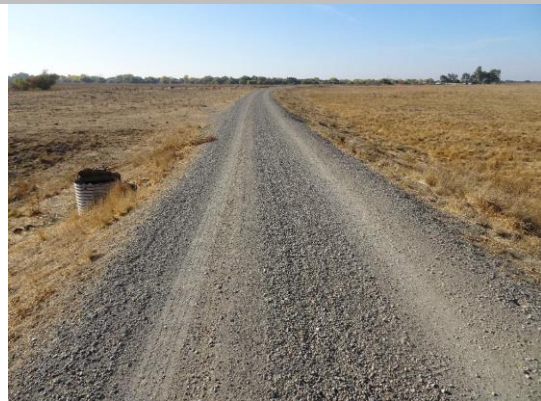
Photo 1 of 3 : UCIP_SP_2022_70712_90861.jpg

FS_ID:70712
DS_ID:19594
EP_NO: N/A
Repair Type: Non-Urgent
Crossing Status: Found
UCIP Comments: 11/16/2020 Record remains Non-Urgent. Unable to locate pipe on the WS. Pipe appears to be buried on WS. Sediment build-up observed at the LS inlet. Recommend sediment removal and evaluation of pipe's purpose. Pipe is currently non-functional. No permit was found authorizing this encroachment. CVFPB will need to review crossing to determine owner. DWR DMP internal inspection is pending and scheduled for 2021. Recommend adding riser cover on the WS as a safety measure. (B. Singh - GEI, O. Magana - DWR UCIP)04/25/2014 Non-functional crossing--pipe is buried on waterward side. Sediment buildup in pipe visible from landward side. Need to coordinate with owner to determine status. If crossing is no longer in use, owner will need to coordinate with DWR Inspector and CVFPB to properly abandon. (O. Magana - DWR UCIP)

Overview of levee crown

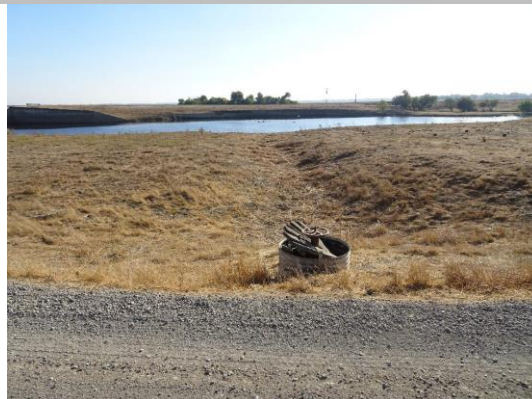
Photo 2 of 3 : UCIP_SP_2022_70712_90862.jpg

Pipe riser visible on WS slope

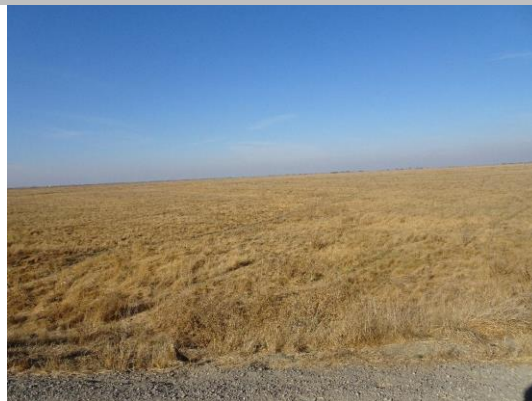
Photo 3 of 3 : UCIP_SP_2022_70712_90863.jpg

View landward

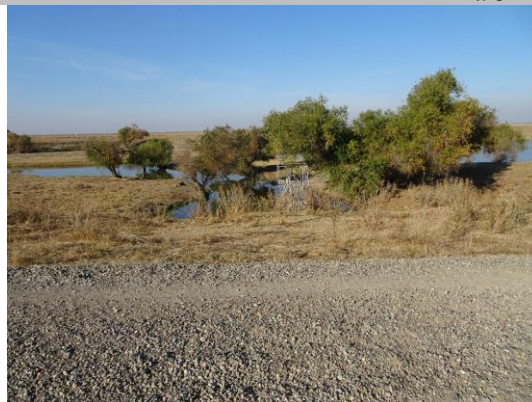
Photo 2 of 3 : UCIP_SP_2022_70713_90867.jpg

WS view: overview of WS

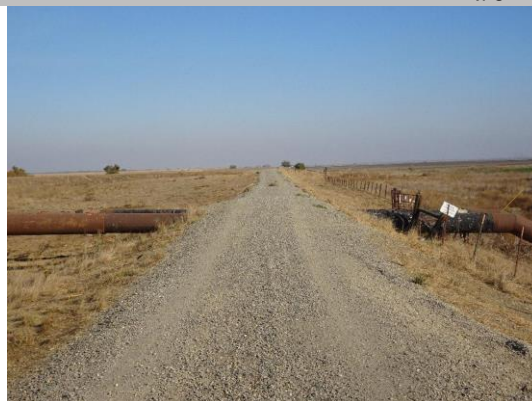
Photo 1 of 3 : UCIP_SP_2022_70714_90879.jpg

FS_ID:70714
 DS_ID:24872
 EP_NO: N/A
 Repair Type: Non-Urgent
 Crossing Status: Found
 UCIP Comments: 11/16/2020 Record remains Non-Urgent. No permit was found authorizing this encroachment. CVFPB will need to review crossing to determine owner. Pipe measured as 24 inches in diameter at LS outlet. Field structure was updated with updated diameter information. (B. Singh - GEI, O. Magana - DWR UCIP)04/25/2014
 New crossing found during field inspection--Need to contact owner to obtain additional information about crossing. (O. Magana - DWR UCIP)
 FIELD_STRUCT_DESC: 2 of 2: 24-inch steel drainage discharge pipe through the levee, at an unknown depth. Pump station and electrical panel on the landside (LS). This pipe was field discovered.
 FS Date: 11/16/2020

Overview of levee crown looking d/s

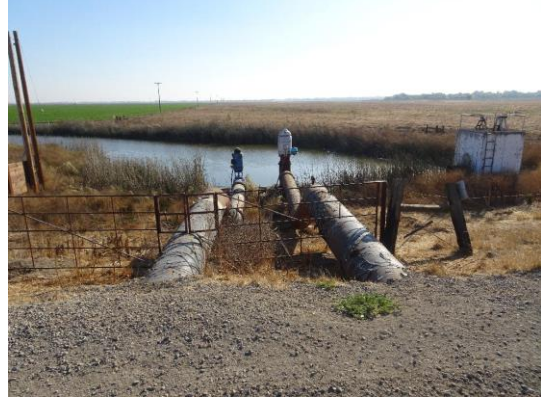
Photo 2 of 3 : UCIP_SP_2022_70714_90880.jpg

WS view: pipes visible on LS

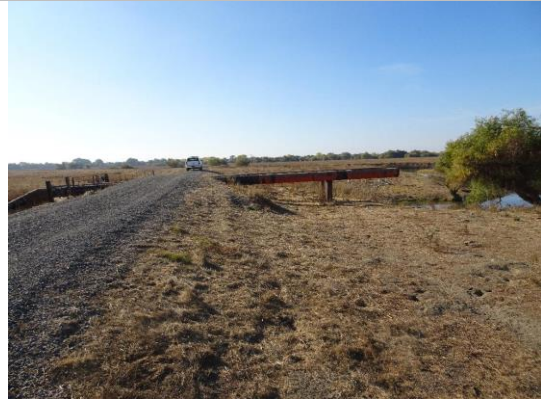
Photo 3 of 3 : UCIP_SP_2022_70714_90881.jpg

WS view: overview of WS slope

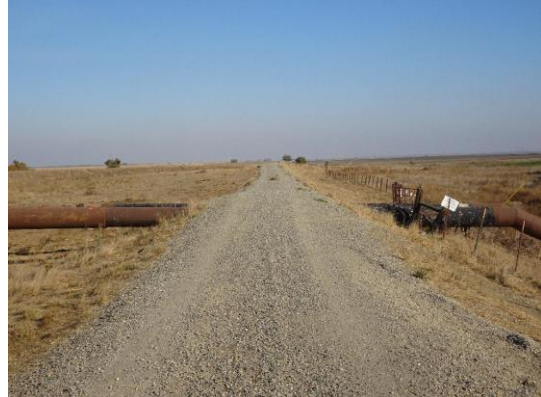
Photo 1 of 3 : UCIP_SP_2022_70715_90885.jpg

Comment Code					
Inspector Comment					
FS_ID:70715 DS_ID:19595 EP_NO: 5983 Repair Type: Non-Urgent Crossing Status: Found UCIP Comments: 11/16/2020 Record remains Non-Urgent. No permit was found authorizing this encroachment. CVFPB will need to review crossing to determine owner. DWR DMP internal inspection is pending and scheduled for 2021. (B. Singh - GEI, O. Magana - DWR UCIP) FIELD_STRUCT_DESC: 60-inch corrugated metal (CM) gravity drainage pipe through the levee, 21.0 feet below the crown. Concrete U-shaped headwall and splash apron on the landside (LS) end. 7-foot by 8-foot by 20.5-foot concrete drainage structure around the LS end of the pipe. Flap gate over pipe opening inside drainage structure. Pump on discharge structure on the LS slope. Steel discharge pipe through the upstream wall of the structure. (Drainage pump structure and appurtenances on preexisting drainage pipe authorized under Permit No. 5983, 1968 - Turner Island Water District). [Additional Reference(s): DWR Levee Log, 2002, (HLM 19.33). USACE San Joaquin O&M Manual, Unit No. 601, Part No. 1, (SJR601.1), 1967, Revised 25 May 2011, (HLM 19.34)]. FS Date: 11/16/2020

Overview of levee crown

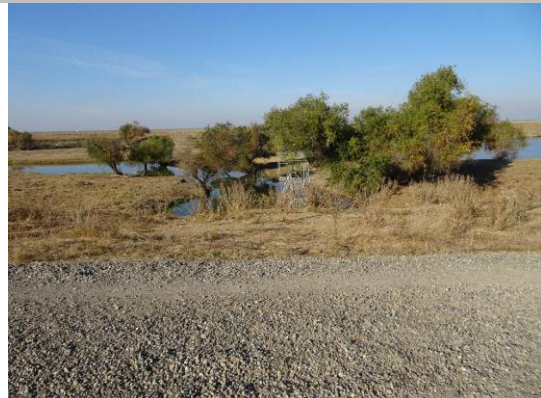
Photo 2 of 3 : UCIP_SP_2022_70715_90886.jpg

WS view: overview of WS

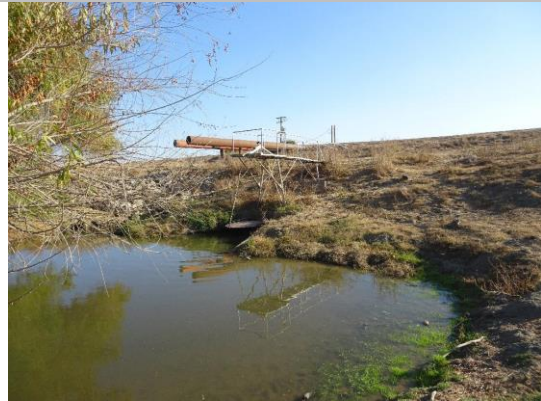
Photo 3 of 3 : UCIP_SP_2022_70715_90887.jpg

WS view: view of outlet on WS toe with gate open

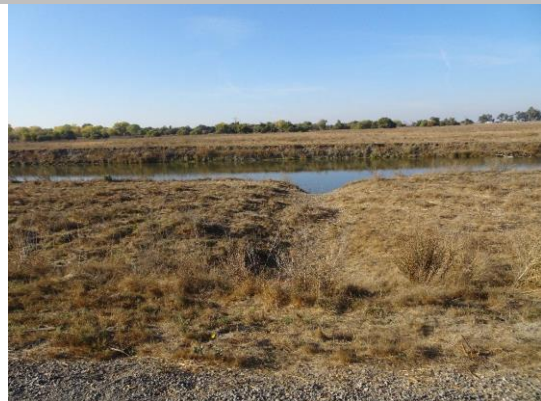
Photo 1 of 3 : UCIP_SP_2022_70716_90890.jpg

FS_ID:70716
DS_ID:19596
EP_NO: N/A
Repair Type: Non-Urgent
Crossing Status: Found
UCIP Comments: 11/16/2020 Record remains Non-Urgent. No permit was found authorizing this encroachment. CVFPB will need to review crossing to determine owner. DWR DMP has not found internal issues, LOF between 1 and 2. Recommend inspection in 5 years. (B. Singh - GEI, O. Magana - DWR UCIP)04/25/2014 Dense vegetation limits the inspector's visibility to identify signs of pipe failure (leaks) along the waterward slope. Recommend removing vegetation along pipe alignment to conduct proper inspection of structure. Dense vegetation blocks both waterward and landward headwalls. Sediment buildup in pipe visible from landward side. (O. Magana - DWR UCIP)
FIELD_STRUCT_DESC: 24-inch corrugated metal (CM) gravity drainage pipe through the levee, 8.0 feet below the crown. Flap gate on the waterside (WS) end. Brass cap No. 40 bench mark (BM) on the headwall on the landside (LS). [Additional Reference(s): DWR Levee Log, 2002, (HLM 19.54). USACE San Joaquin O&M Manual, Unit No. 601, Part No. 1, (SJR601.1), 1967, Revised 25 May 2011, (HLM 19.54)].

WS view: overview of WS

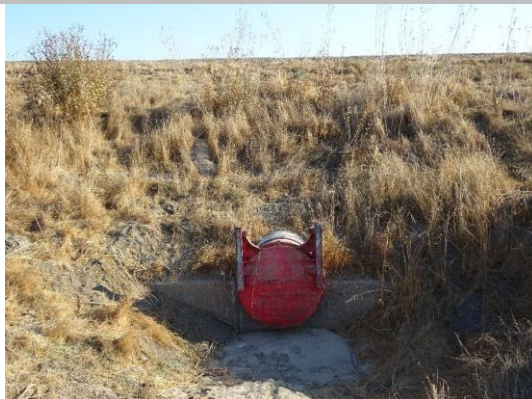
Photo 2 of 3 : UCIP_SP_2022_70716_90889.jpg

WS view: concrete headwall, flap gate, and WS slope visible on WS.

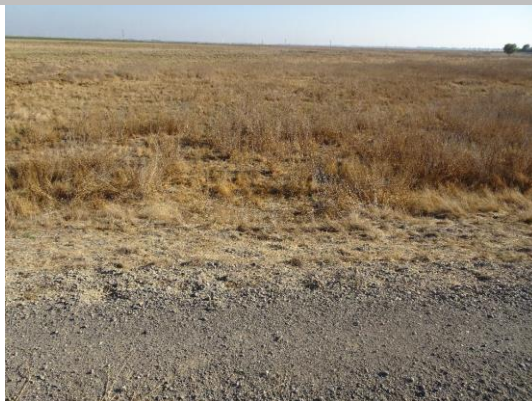
Photo 3 of 3 : UCIP_SP_2022_70716_90891.jpg

LS view: overview of LS

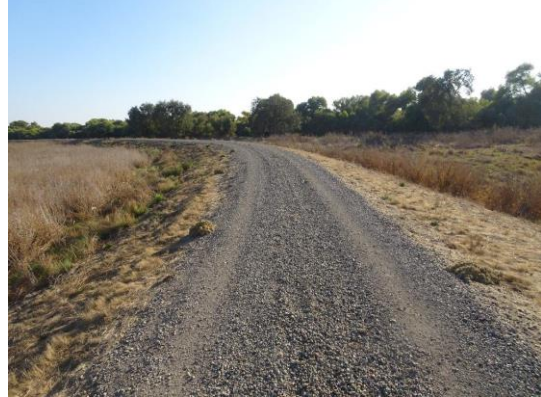
Photo 1 of 3 : UCIP_SP_2022_70717_90896.jpg

FS_ID:70717
DS_ID:19597
EP_NO: N/A
Repair Type: Non-Urgent
Crossing Status: Indicator Found
UCIP Comments: 11/16/2020 Record remains Non-Urgent. No permit was found authorizing this encroachment. CVFPB will need to review crossing to determine owner. DWR DMP internal inspection is pending and scheduled for 2021. (B. Singh - GEI, O. Magana - DWR UCIP)04/25/2014 No photos available for crossing--crossing missed. Recommend taking photos to confirm status of crossing. (O. Magana - DWR UCIP)
FIELD_STRUCT_DESC: 24-inch corrugated metal (CM) gravity drainage pipe through the levee, 8.0 feet below the crown. Flap gate on the waterside (WS) end. Brass cap No. 40 bench mark (BM) on the headwall on the landside (LS). [Additional Reference(s): DWR Levee Log, 2002, (HLM 19.82). USACE San Joaquin O&M Manual, Unit No. 601, Part No. 1, (SJR601.1), 1967, Revised 25 May 2011, (HLM 19.81)].
FS Date: 11/16/2020

Overview of levee crown looking u/s

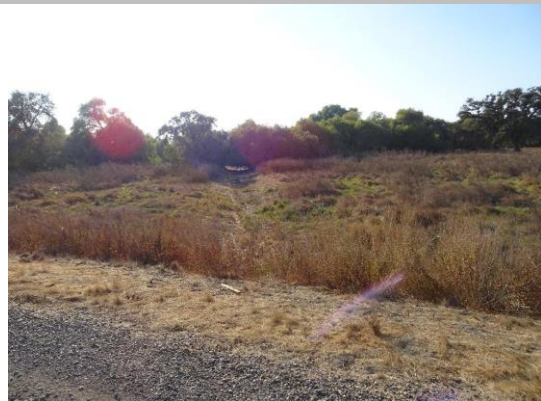
Photo 2 of 3 : UCIP_SP_2022_70717_90897.jpg

WS view: view of WS

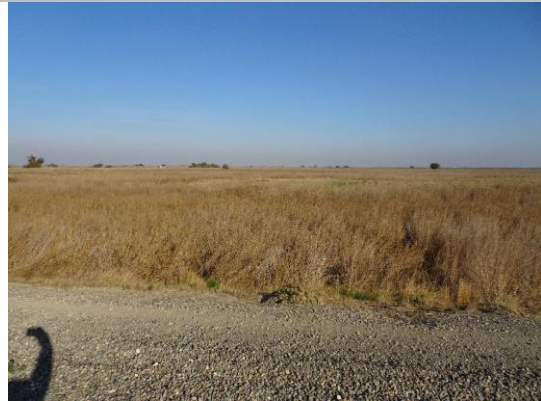
Photo 3 of 3 : UCIP_SP_2022_70717_90898.jpg

LS view: view of LS

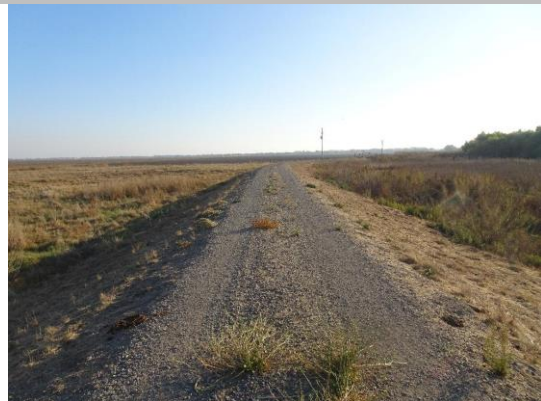
Photo 1 of 3 : UCIP_SP_2022_70718_90903.jpg

FS_ID:70718
 DS_ID:19598
 EP_NO: N/A
 Repair Type: Non-Urgent
 Crossing Status: Found
 UCIP Comments: 11/16/2020 Record remains Non-Urgent. Limited access due to steep slopes. No permit was found authorizing this encroachment. CVFPB will need to review crossing to determine owner. DWR DMP internal inspection is pending and scheduled for 2021. (B. Singh - GEI, O. Magana - DWR UCIP)04/25/2014 Recommend removing vegetation and sediment buildup from both waterward and landward concrete headwalls. (O. Magana - DWR UCIP)
 FIELD_STRUCT_DESC: 24-inch corrugated metal (CM) gravity drainage pipe through the levee, 8.5 feet below the crown. Flap gate on the waterside (WS) end. Brass cap No. 40 bench mark (BM) on the headwall on the landside (LS). [Additional Reference(s): DWR Levee Log, 2002, (HLM 20.19). USACE San Joaquin O&M Manual, Unit No. 601, Part No. 1, (SJR601.1), 1967, Revised 25 May 2011, (HLM 20.18)].

Overview of levee crown looking upstream

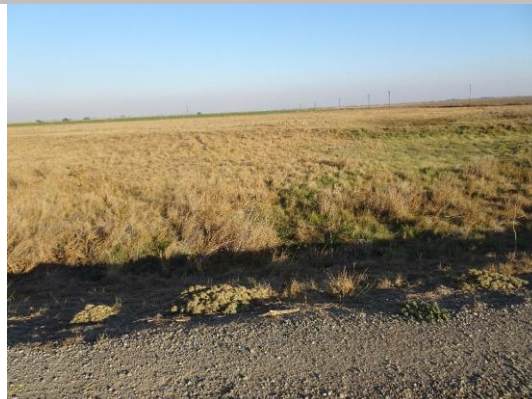
Photo 2 of 3 : UCIP_SP_2022_70718_93061.jpg

LS view: overview of LS.

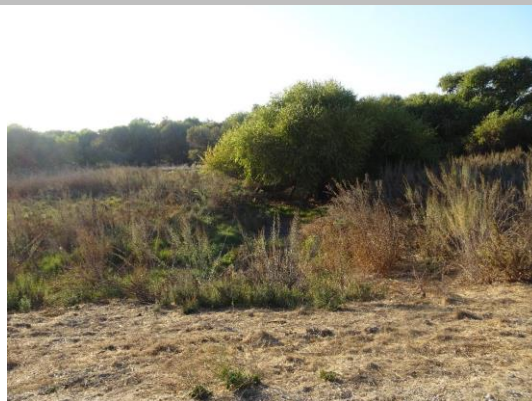
Photo 3 of 3 : UCIP_SP_2022_70718_93060.jpg

WS view: overview of WS.

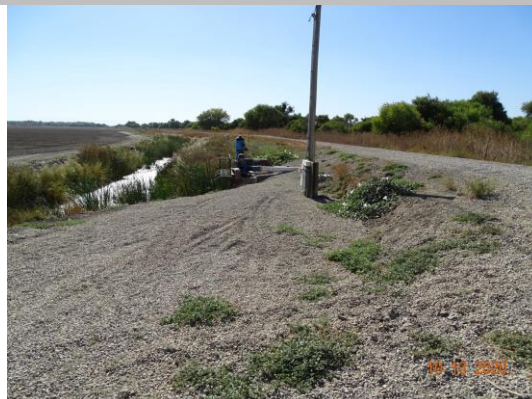
Photo 1 of 1 : SP_2022_NA0010_118_1184_20220308_00032.jpg

LM Start	20.25	Rating **	M	Issue No.	1184
LM End	20.25	Issue Type +	En	Location *	LS
Category	Earthen Levee			GPS Latitude/Longitude	
				Start	End
Item	Encroachments			37.193657 °	37.193657 °
				-120.760138 °	-120.760138 °
DWR ID	DWR_NA0010_01_s_2015_1184				
Comment Code					
RA : Ramp					
Inspector Comment					
Landowner installed unauthorized ramp on landside slope and toe.

Ramp cut into to the landside slope to access irrigation ditch at the landside toe. (Fall 2020)

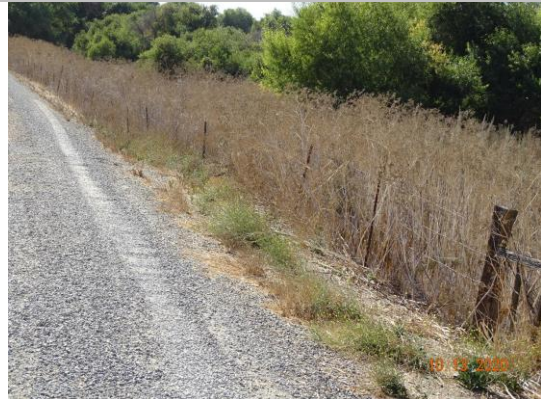
Photo 1 of 1 : SP_2022_NA0010_118_106_20220308_00010.jpg

LM Start	20.25	Rating **	M	Issue No.	106
LM End	22.51	Issue Type +	En	Location *	WS
Category	Earthen Levee			GPS Latitude/Longitude	
				Start	End
Item	Encroachments			37.193663 °	37.166957 °
				-120.760148 °	-120.750080 °
DWR ID	DWR_NA0010_01_f _ 2020_106				
Comment Code					
FE : Fence					
Inspector Comment

Barbed wire fence along the waterside slope. (Fall 2020)

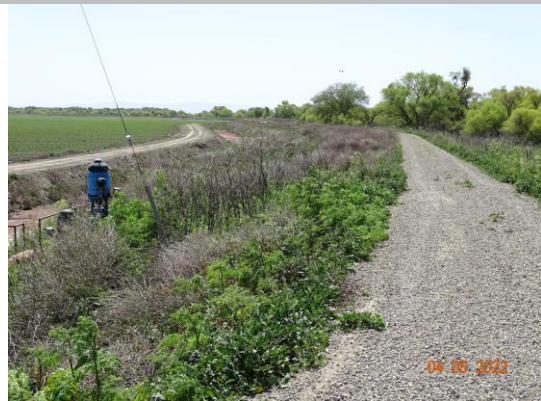
Photo 1 of 1 : SP_2022_NA0010_118_141_20220412_00308.jpg

LM Start	20.26	Rating **	U	Issue No.	141
LM End	21.63	Issue Type +	Ma	Location *	LS
Category	Earthen Levee			GPS Latitude/Longitude	
				Start	End
Item	Vegetation			37.193641 °	37.177626 °
				-120.760183 °	-120.757951 °
DWR ID	DWR_NA0010_01_s_2022_141				
Comment Code					
V1 : Control annual grass and weeds on the levee slopes and easements.					
Inspector Comment

View of vegetation on the landside slope looking upstream. (Spring 2022)

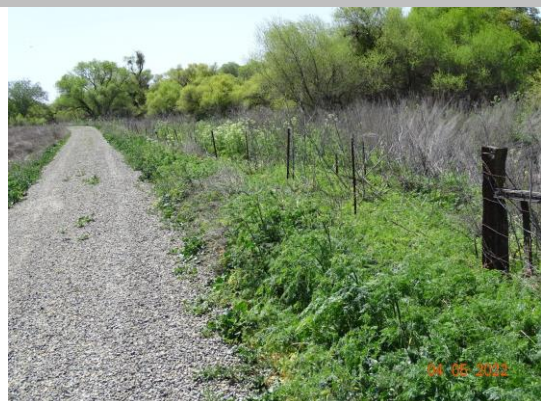
Photo 1 of 1 : SP_2022_NA0010_118_142_20220412_00311.jpg

LM Start	20.26	Rating **	M	Issue No.	142
LM End	22.50	Issue Type +	Ma	Location *	WS
Category	Earthen Levee			GPS Latitude/Longitude	
				Start	End
Item	Vegetation			37.193632 °	37.167104 °
				-120.760194 °	-120.750272 °
DWR ID	DWR_NA0010_01_s_2022_142				
Comment Code					
V1 : Control annual grass and weeds on the levee slopes and easements.					
Inspector Comment

View of vegetation growing on the waterside slope. (Spring 2022)

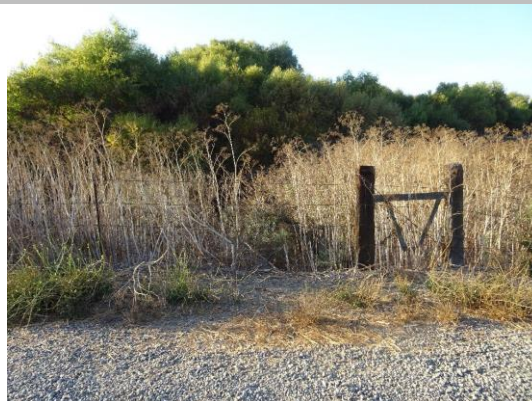
Photo 2 of 3 : UCIP_SP_2022_70719_91025.jpg

WS view: overview of WS

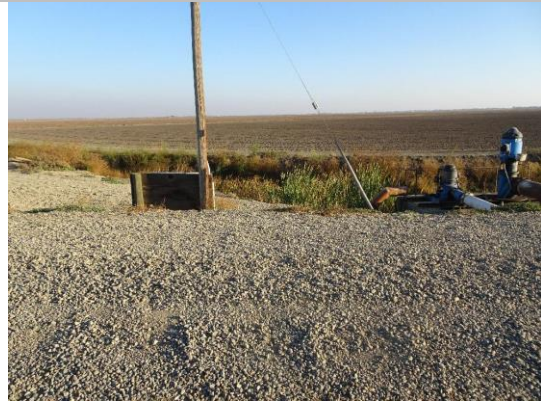
Photo 3 of 3 : UCIP_SP_2022_70719_91026.jpg

LS view: overview of LS

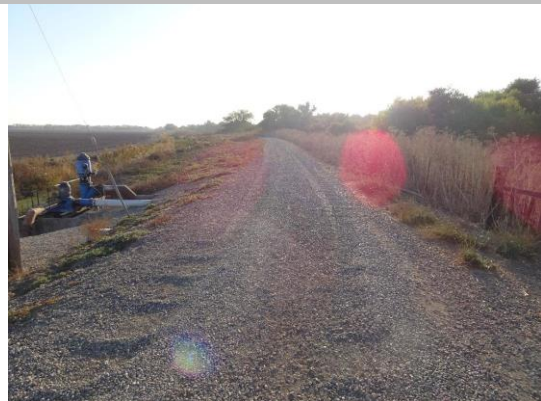
Photo 1 of 3 : UCIP_SP_2022_70720_91023.jpg

FS_ID:70720
DS_ID:19599
EP_NO: N/A
Repair Type: Non-Urgent
Crossing Status: Found
UCIP Comments: 11/16/2020 Record remains Non-Urgent. Fence on the WS inhibited proper inspection. No permit was found authorizing this encroachment. CVFPB will need to review crossing to determine owner. (B. Singh - GEI, O. Magana - DWR UCIP)7/19/2016 same as previous inspection. crossing was downgraded from Urgent to Non-Urgent due to metal rod not interfering with flap gate. (O. Magana - DWR UCIP)4/25/2014 Unauthorized crossing through pipe. Line was pushed through existing crossing. Need to contact owner. Also sediment buildup in pipe visible from landward side--recommend clearing. (O. Magana - DWR UCIP)
FIELD_STRUCT_DESC: 24-inch corrugated metal (CM) gravity drainage pipe through the levee, 5.0 feet below the crown. Flap gate on the waterside (WS) end. [Additional Reference(s): DWR Levee Log, 2002, (HLM 20.27)].

Overview of levee crown

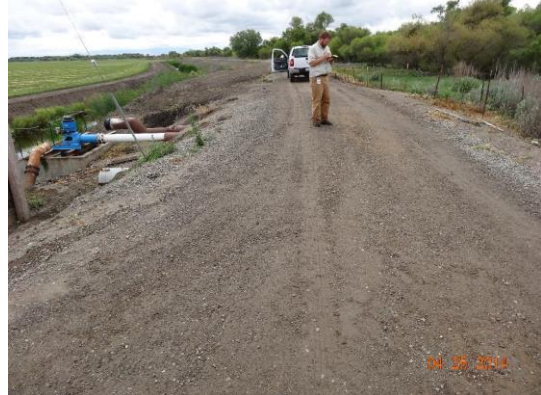
Photo 1 of 3 : UCIP_SP_2022_70721_66308.jpg

FS_ID:70721
DS_ID:19600
EP_NO: N/A
Repair Type: Non-Urgent
Crossing Status: Found
UCIP Comments: 11/16/2020 Record remains Non-Urgent. Dense vegetation and fence on the WS prevented proper inspection of pipe. No permit has been found authorizing this pipe. CVFPB will need to review crossing to determine owner. (O. Magana - DWR UCIP)04/25/2014 Crossing partially submersed--no signs of failure of pipe present along pipe alignment. Recommend contacting owner to determine status of crossing and condition. (O. Magana - DWR UCIP) FIELD_STRUCT_DESC: 36-inch corrugated metal (CM) gravity drainage pipe through the levee, 10.5 feet below the crown. Flap gate on the waterside (WS) end. Brass cap No. 40 bench mark (BM) on the headwall on the landside (LS). [Additional Reference(s): DWR Levee Log, 2002, (HLM 20.28). USACE San Joaquin O&M Manual, Unit No. 601, Part No. 1, (SJR601.1), 1967, Revised 25 May 2011, (HLM 20.27)]. FS Date: 11/6/2020

Overview of levee crown at crossing--multiple crossings at this location.

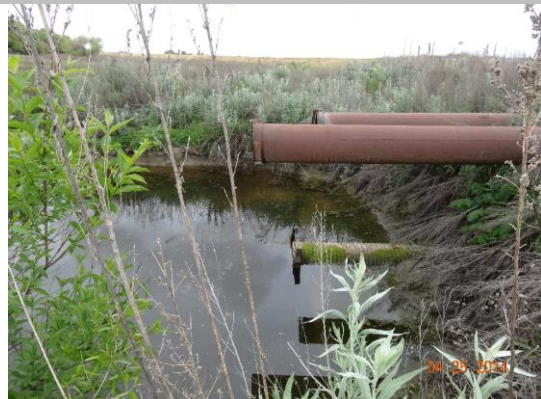
Photo 2 of 3 : UCIP_SP_2022_70721_66309.jpg

Multiple crossings visible on waterward side--36 inch CMP is submersed in water.

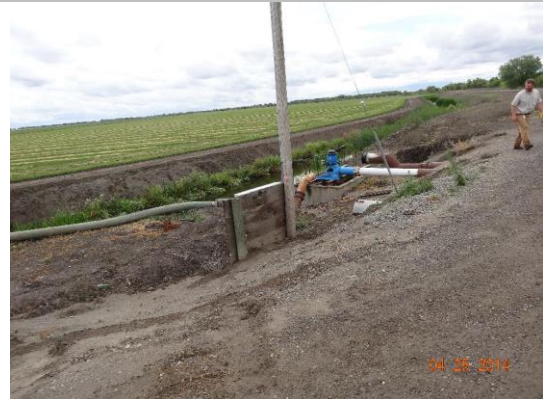
Photo 3 of 3 : UCIP_SP_2022_70721_66307.jpg

View of landward side.

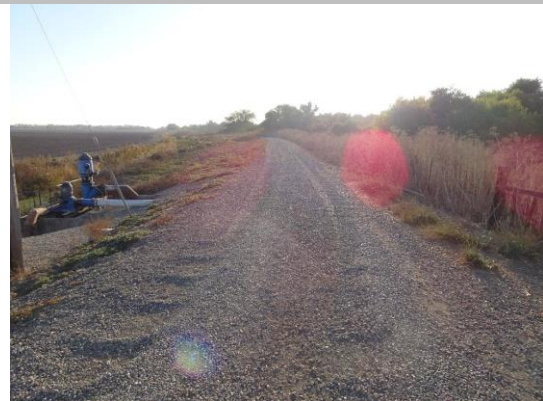
Photo 1 of 3 : UCIP_SP_2022_70722_91014.jpg

FS_ID:70722
DS_ID:24873
EP_NO: N/A
Repair Type: Non-Urgent
Crossing Status: Found
UCIP Comments: 11/16/2020 Record remains Non-Urgent. Dense vegetation and fence on the WS inhibited proper inspection. No permit was found authorizing this encroachment. CVFPB will need to review crossing to determine owner. System description was updated based on measured diameters for the outer pipe and sleeved pipe. (B. Singh - GEI, O. Magana - DWR UCIP)04/25/2014 Dense vegetation limits the inspector's visibility to identify signs of pipe failure (leaks) along the waterward slope. Recommend removing vegetation along pipe alignment to conduct proper inspection of structure. (DWR UCIP - O. Magana)
FIELD_STRUCT_DESC: 14-inch steel pipe containing a 9-inch steel drainage discharge pipe through the levee, at an unknown depth.
FS Date: 11/16/2020

Overview of levee crown

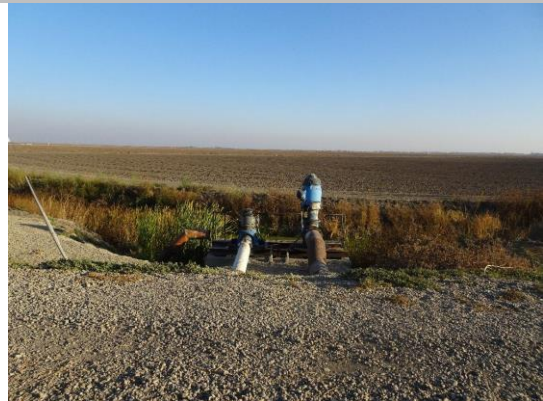
Photo 3 of 3 : UCIP_SP_2022_70722_91017.jpg

View landward and pipes

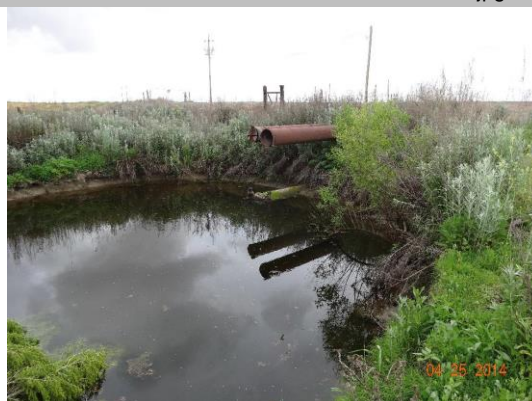
Photo 2 of 3 : UCIP_SP_2022_70723_71441.jpg

View of waterward side.

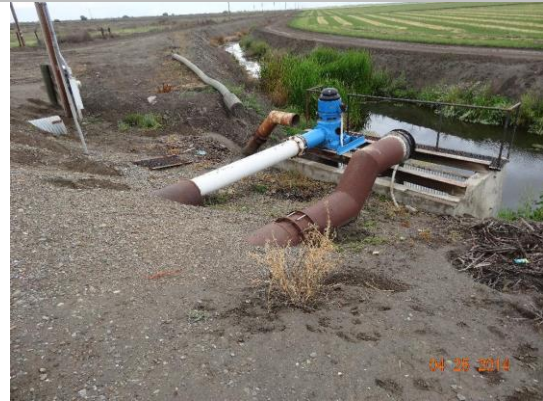
Photo 3 of 3 : UCIP_SP_2022_70723_71440.jpg

View of landward side.

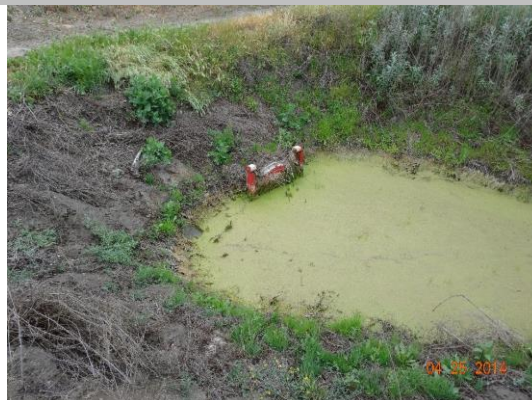
Photo 2 of 3 : UCIP_SP_2022_70727_66313.jpg

Flap gate half way submersed located on waterward side.

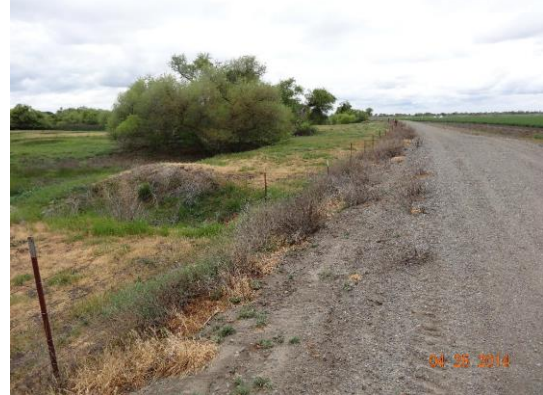
Photo 1 of 3 : UCIP_SP_2022_70728_65697.jpg

FS_ID:70728
DS_ID:19604
EP_NO: N/A
Repair Type: Non-Urgent
Crossing Status: Found
UCIP Comments: 05/06/2021 Record remains Non-Urgent. This crossing appears to be non-functional based on the 2014 UCIP inspection. No field inspection has been completed by UCIP. DWR DMP internal inspection is pending and scheduled for 2021. Recommend having UCIP inspector or Levee inspector take current photos of the site. (O. Magana - DWR UCIP)04/25/2014 Non-functional crossing-landward side is buried. Need to contact owner to determine status of crossing. If crossing is no longer used need to coordinate with CVFPB for proper abandonment. (O. Magana - DWR UCIP)
FIELD_STRUCT_DESC: 24-inch corrugated metal (CM) gravity drainage pipe through the levee, 9.0 feet below the crown. Flap gate on the waterside (WS) end. Brass cap No. 40 bench mark (BM) on the headwall on the landside (LS). [Additional Reference(s): DWR Levee Log, 2002, (HLM 21.78). USACE San Joaquin O&M Manual, Unit No. 601, Part No. 1, (SJR601.1), 1967, Revised 25 May 2011, (HLM 21.76)].

View of waterward side.

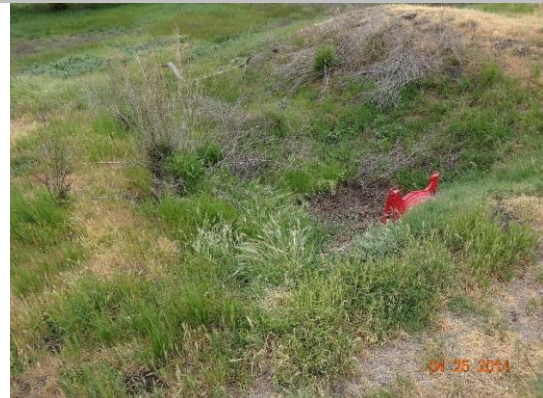
Photo 2 of 3 : UCIP_SP_2022_70728_65695.jpg

Flap gate visible on waterward side.

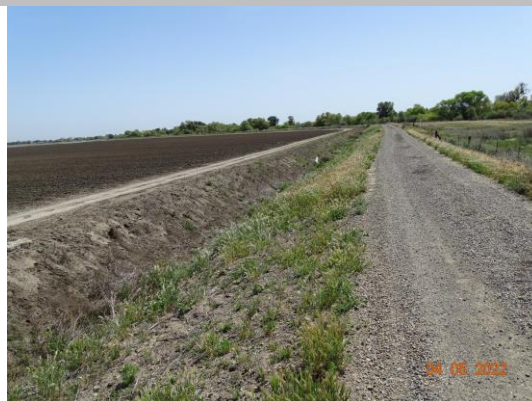
Photo 1 of 1 : SP_2022_NA0010_118_22_20220412_00312.jpg

LM Start	22.06	Rating **	U	Issue No.	22
LM End	22.52	Issue Type +	En	Location *	LS
Category	Earthen Levee			GPS Latitude/Longitude	
				Start	End
Item	Encroachments			37.172074 °	37.166906 °
				-120.754628 °	-120.749962 °
DWR ID	DWR_NA0010_01_s_2020_22				
Comment Code					
DT : Ditch					
Inspector Comment					
Ditch has encroached into landside toe and slope.

Looking upstream at irrigation at landside toe. (Spring 2022)

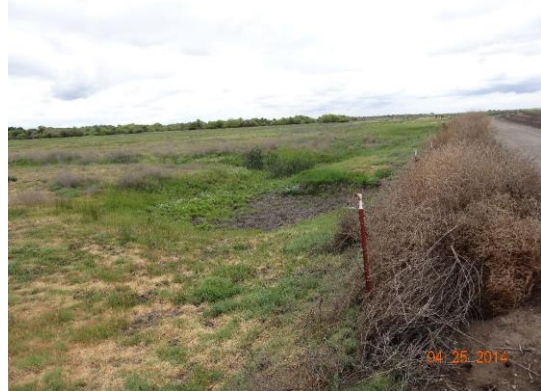
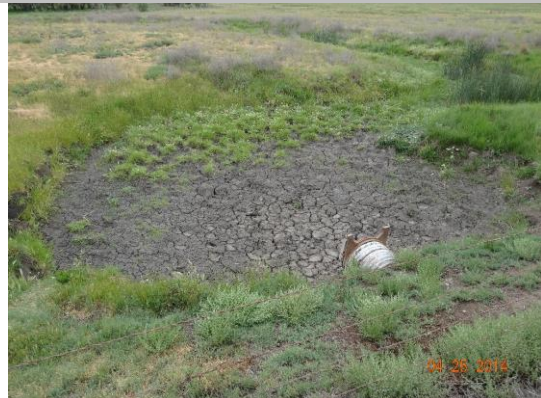
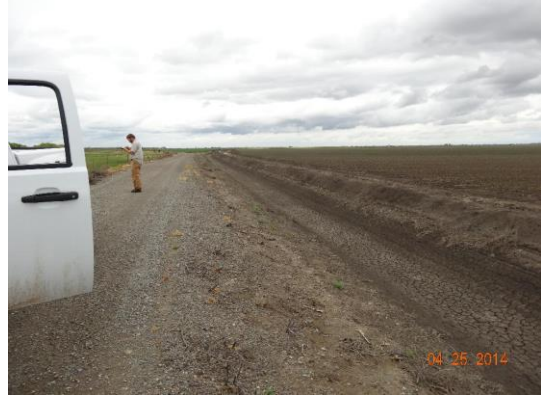
Comment Code					
Inspector Comment					
FS_ID:70729 DS_ID:19605 EP_NO: N/A Repair Type: Non-Urgent Crossing Status: Found UCIP Comments: 05/06/2021 Record remains Non-Urgent. This crossing appears to be non-functional based on the 2014 UCIP inspection. No field inspection has been completed by UCIP. DWR DMP internal inspection is pending and scheduled for 2021. Recommend having UCIP inspector or Levee inspector take current photos of the site. (O. Magana - DWR UCIP)04/25/2014 Non-functional crossing--landward side is buried. Need to contact owner to determine status. If crossing is no longer used need to coordinate with CVFPB for proper abandonment. (O. Magana - DWR UCIP) FIELD_STRUCT_DESC: 24-inch corrugated metal (CM) gravity drainage pipe through the levee, 9.0 feet below the crown. Flap gate on the waterside (WS) end. Wooden headboards on the landside (LS) end. Brass cap No. 31 bench mark (BM) on the headwall on the LS. [Additional Reference(s): DWR Levee Log, 2002, (HLM 22.13). USACE San Joaquin O&M Manual, Unit No. 601, Part No. 1, (SJR601.1), 1967, Revised 25 May 2011, (HLM 22.13)]. FS Date: 5/6/2021 9:50:00 AM

View of waterward side.

Flap gate visible on waterward side.

View of landward side.

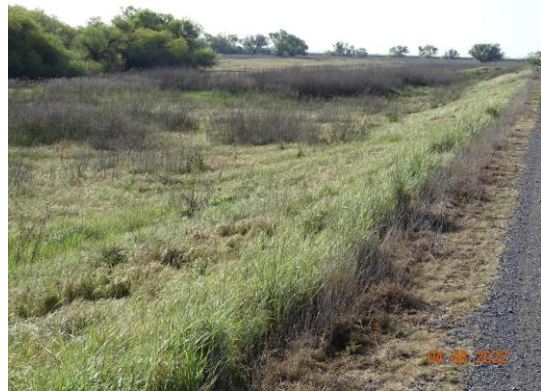
Photo 1 of 1 : SP_2022_NA0010_119_25_20220412_00070.jpg

LM Start	0.06	Rating **	M	Issue No.	25
LM End	6.81	Issue Type +	Ma	Location *	WS
Category	Earthen Levee			GPS Latitude/Longitude	
				Start	End
Item	Vegetation			37.295683 °	37.243355 °
				-120.880082 °	-120.822434 °
DWR ID	DWR_NA0010_02A_s _ 2022_25				
Comment Code					
V1 : Control annual grass and weeds on the levee slopes and easements.					
Inspector Comment

Looking upstream along the waterside slope. (Spring 2022)

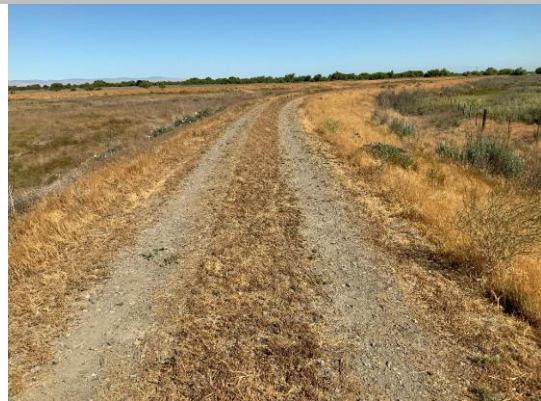
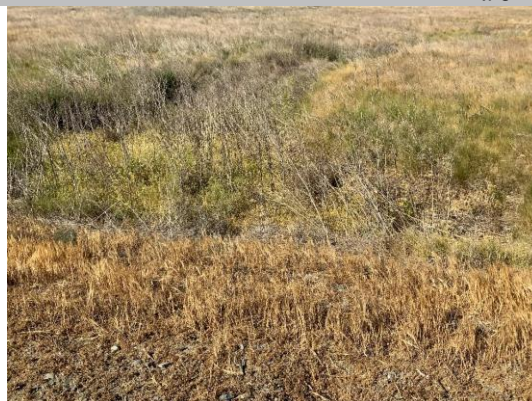
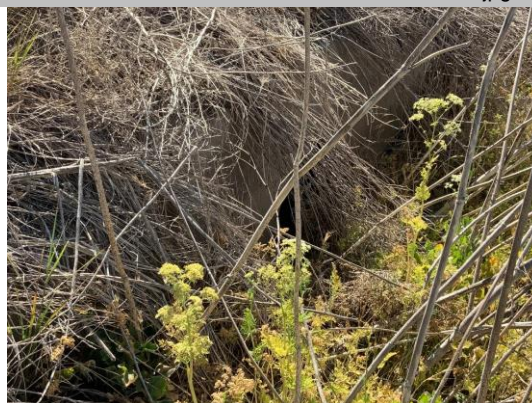
Comment Code						
Inspector Comment						
FS_ID:70933 DS_ID:19652 EP_NO: N/A Repair Type: Non-Urgent Crossing Status: Found UCIP Comments: 06/8/2021 Record remains Non-Urgent. There is dense vegetation around the LS pipe inlet, recommend removing to better inspect pipe. No permit was found authorizing this encroachment. CVFPB will need to review crossing to determine owner. The UCIP inspection was completed with GEI staff, P. Espinoza. (H. Dunn ? GEI) 05/01/2014 Dense vegetation limits the inspector's visibility to identify signs of pipe failure (leaks) along the slope. Recommend removing vegetation along pipe alignment to conduct proper inspection of structure. (O. Magana - DWR UCIP) FIELD_STRUCT_DESC: 24-inch corrugated metal gravity drainage pipe (CMP) through the levee, 11.0 feet below the crown. Flap gate on the waterside (WS) end. Brass cap No. 139 bench mark (BM) on the headwall on the landside (LS). [Additional Reference(s): DWR Levee Log, 2002, (HLM 0.24). USACE San Joaquin O&M Manual, Unit No. 601, Part No. 1, 1967, Amended in 1978, Revised 20 June 1985, (HLM 0.24)]. FS Date: 6/8/2021

LS view: Close up of pipe inlet at toe, vegetation covering opening.

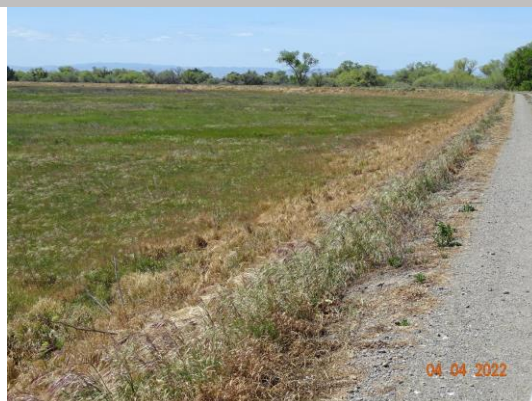
Photo 1 of 1 : SP_2022_NA0010_119_24_20220412_00071.jpg

LM Start	0.63	Rating **	M	Issue No.	24
LM End	4.11	Issue Type +	Ma	Location *	LS
Category	Earthen Levee			GPS Latitude/Longitude	
				Start	End
Item	Vegetation			37.288481 °	37.278105 °
				-120.875171 °	-120.832506 °
DWR ID	DWR_NA0010_02A_s_2022_24				
Comment Code					
V1 : Control annual grass and weeds on the levee slopes and easements.					
Inspector Comment

View of the landside slope looking downstream. (Spring 2022)

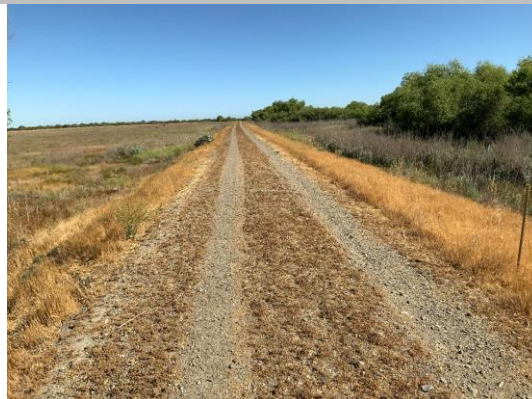
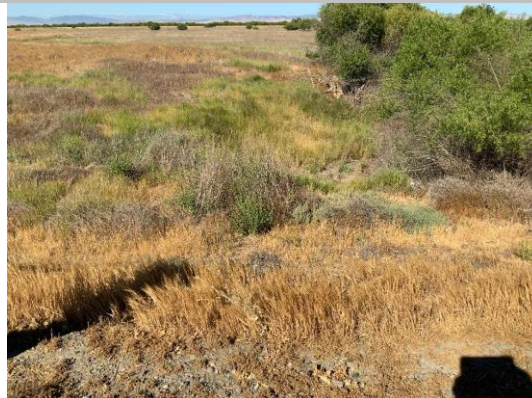
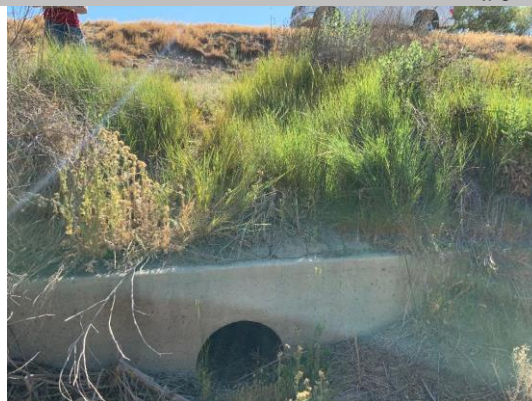
Comment Code						
Inspector Comment						
FS_ID:70934 DS_ID:19653 EP_NO: N/A Repair Type: Non-Urgent Crossing Status: Found UCIP Comments: 06/8/2021 The record remains Non-Urgent. Some vegetation debris inside LS pipe inlet, recommend removal. No permit was found authorizing this encroachment. CVFPB will need to review crossing to determine owner. The UCIP inspection was completed with GEI staff, P. Espinoza. (H. Dunn ? GEI) 05/01/2014 Dense vegetation limits the inspector's visibility to identify signs of pipe failure (leaks) along the slope. Recommend removing vegetation along pipe alignment to conduct proper inspection of structure. (O. Magana - DWR UCIP) FIELD_STRUCT_DESC: 24-inch corrugated metal gravity drainage pipe (CMP) through the levee, 14.8 feet below the crown. Flap gate on the waterside (WS) end. Brass cap No. 138 bench mark (BM) on the headwall on the landside (LS). [Additional Reference(s): DWR Levee Log, 2002, (HLM 0.69). USACE San Joaquin O&M Manual, Unit No. 601, Part No. 1, 1967, Amended in 1978, Revised 20 June 1985, (HLM 0.67)]. FS Date: 6/8/2021

LS view: Slope, headwall, and inlet at toe.

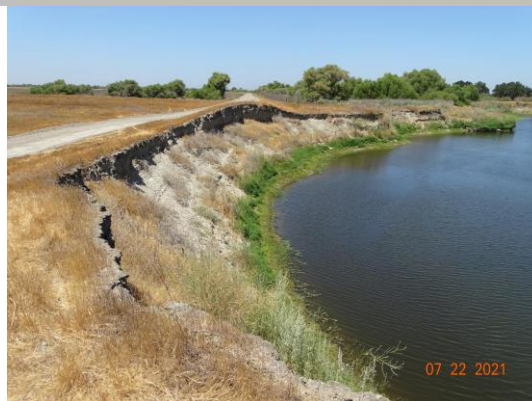
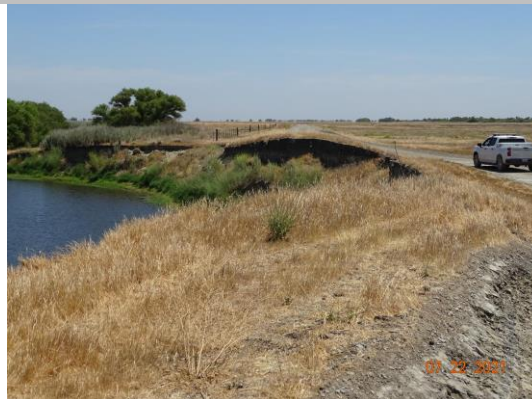
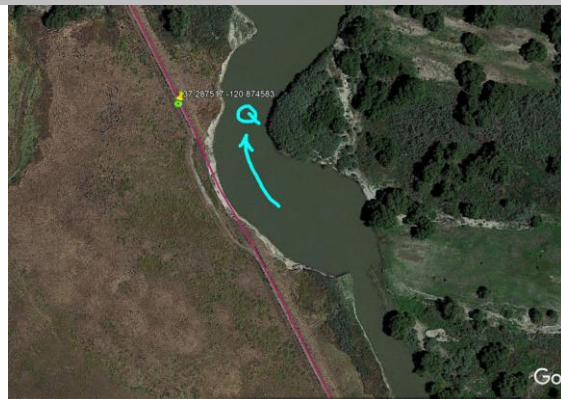
LM Start	0.68	Rating **	U	Issue No.	1
LM End	0.74	Issue Type +	Ma	Location *	WS
Category	Supplemental			GPS Latitude/Longitude	
				Start	End
Item	DWR Erosion Survey			37.287517 °	37.287517 °
				-120.874583 °	-120.874583 °
DWR ID	NA0010U02ARM129.22

07/22/2021: No significant changes were observed since the previous inspection.

08/20/2020: This site was discovered during the DWR Spring 2012 Levee Inspections. A 250-ft long levee section has completely eroded away and no longer provides adequate flood protection. Note: Unit 2A is in the process of being turned over to State Parks.

7/22/2021: View of the erosion and missing levee segment looking downstream.

7/22/2021: View of the eroded levee looking upstream.

8/20/2020: Aerial view of the erosion site (Google Earth Imagery from 7/18/2019).

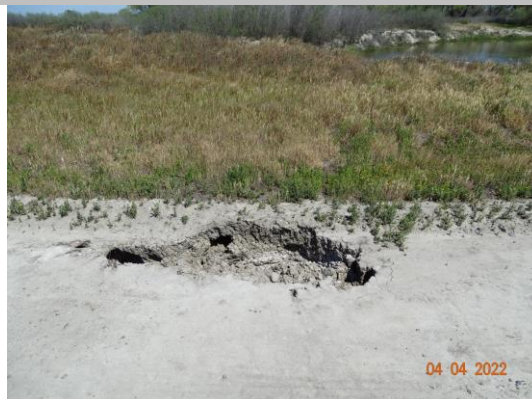
Photo 1 of 1 : SP_2022_NA0010_119_26_20220412_00072.jpg

LM Start	0.74	Rating **	M	Issue No.	26
LM End	0.74	Issue Type +	Ma	Location *	LS
Category	Earthen Levee			GPS Latitude/Longitude	
				Start	End
Item	Animal Control			37.287094 °	37.287094 °
				-120.874422 °	-120.874422 °
DWR ID	DWR_NA0010_02A_s_2022_26				
Comment Code					
A3 : No rodents visible, but rodent burrows visible; need to backfill and compact or grout burrows.					
Inspector Comment					
Rodent burrow caved in along the landside toe. The toe is used in this section to bypass the erosion through the levee crown.

Ground on the landside toe collapsed from rodent activity. (Spring 2022)

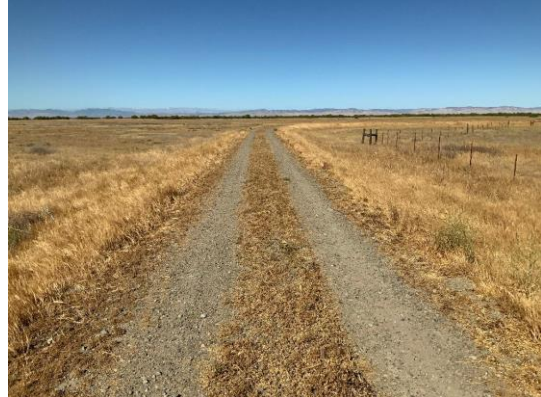
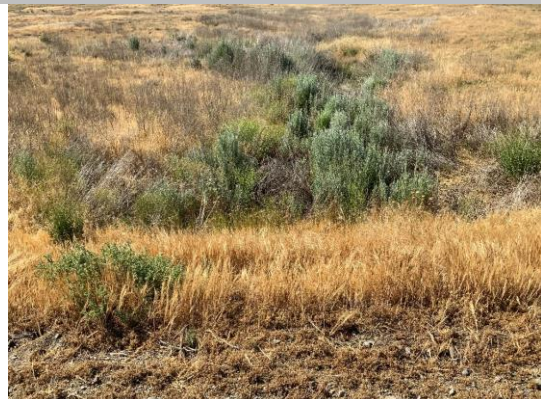
Comment Code						
Inspector Comment						
FS_ID:70935 DS_ID:19654 EP_NO: N/A Repair Type: Non-Urgent Crossing Status: Found UCIP Comments: 06/8/2021 The record remains Non-Urgent. Dense vegetation on LS slope, could not inspect pipe inlet, recommend clearing. No permit was found authorizing this encroachment. CVFPB will need to review crossing to determine owner. The UCIP inspection was completed with GEI staff, P. Espinoza. (H. Dunn ? GEI) 05/01/2014 Dense vegetation limits the inspector's visibility to identify signs of pipe failure (leaks) along the slope. Recommend removing vegetation along pipe alignment to conduct proper inspection of structure. Sediment buildup in pipe recommend clearing. (O. Magana - DWR UCIP) FIELD_STRUCT_DESC: 24-inch corrugated metal gravity drainage pipe (CMP) through the levee, 8.6 feet below the crown. Flap gate on the waterside (WS) end. Brass cap No. 137 bench mark (BM) on the headwall on the landside (LS). [Additional Reference(s): DWR Levee Log, 2002, (HLM 1.03). USACE San Joaquin O&M Manual, Unit No. 601, Part No. 1, 1967, Amended in 1978, Revised 20 June 1985, (HLM 1.02)]. FS Date: 6/8/2021

LS view: Close up of pipe inlet and headwall, covered by vegetation.

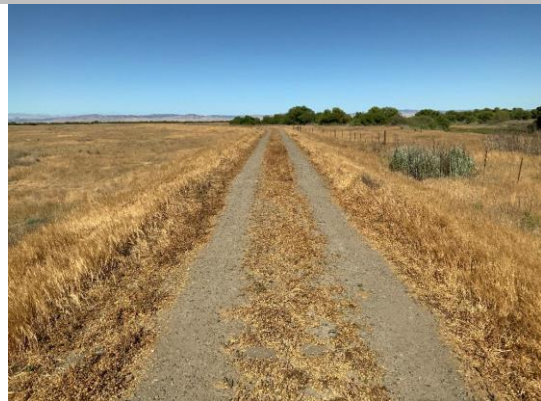
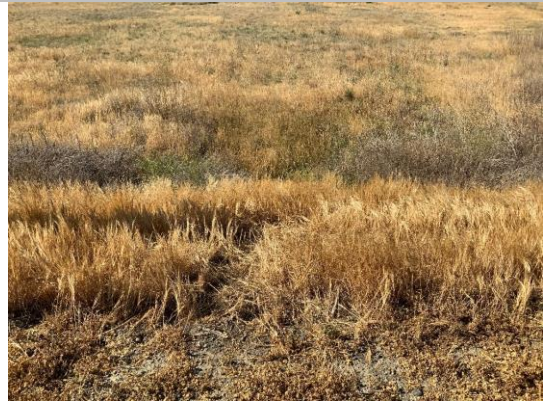
FS_ID:70936
DS_ID:19655
EP_NO: N/A
Repair Type: Non-Urgent
Crossing Status: Found
UCIP Comments: 06/8/2021 The record remains Non-Urgent. Dense vegetation over LS pipe inlet, recommend clearing out for easier pipe inspection. No permit was found authorizing this encroachment. CVFPB will need to review crossing to determine owner. The UCIP inspection was completed with GEI staff, P. Espinoza. (H. Dunn ? GEI)

05/01/2014 Dense vegetation limits the inspector's visibility to identify signs of pipe failure (leaks) along the slope. Recommend removing vegetation along pipe alignment to conduct proper inspection of structure. (O. Magana - DWR UCIP)

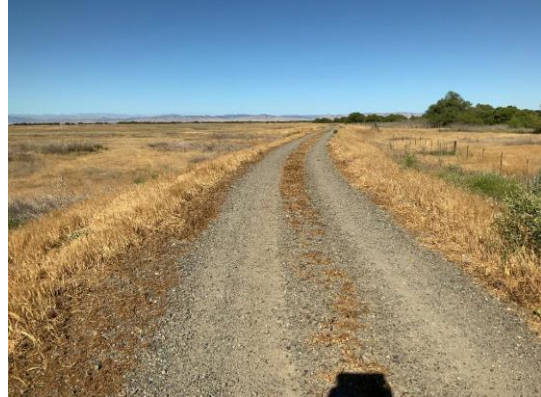
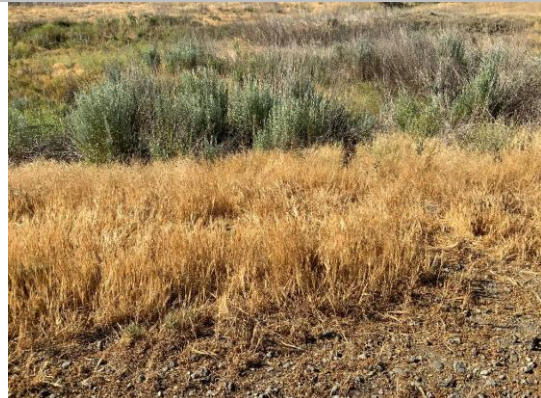
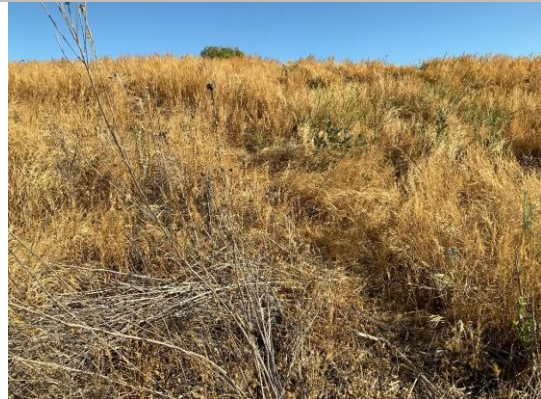
Comment Code						
Inspector Comment						
FS_ID:70937 DS_ID:19656 EP_NO: N/A Repair Type: Non-Urgent Crossing Status: Found UCIP Comments: 06/8/2021 The record remains Non-Urgent. Dense LS vegetation limits inspection of pipe inlet, headwall and inlet not visible at all, recommend clearing. WS flapgate seen with vegetation sticking out of it, recommend removal. No permit was found authorizing this encroachment. CVFPB will need to review crossing to determine owner. The UCIP inspection was completed with GEI staff, P. Espinoza. (H. Dunn ? GEI) 05/01/2014 Dense vegetation limits the inspector's visibility to identify signs of pipe failure (leaks) along the slope. Recommend removing vegetation along pipe alignment to conduct proper inspection of structure. (O. Magana - DWR UCIP) FIELD_STRUCT_DESC: 36-inch corrugated metal gravity drainage pipe (CMP) through the levee, 14.6 feet below the crown. Flap gate on the waterside (WS) end. Brass cap No. 135 bench mark (BM) on the headwall on the landside (LS). [Additional Reference(s): DWR Levee Log, 2002, (HLM 1.36). USACE San Joaquin O&M Manual, Unit No. 601, Part No. 1, 1967, Amended in 1978, Revised 20 June 1985, (HLM 1.34)]. FS Date: 6/8/2021

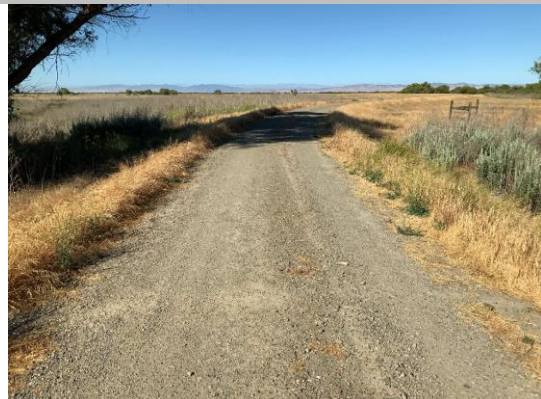
FS_ID:70938
 DS_ID:19657
 EP_NO: N/A
 Repair Type: Non-Urgent
 Crossing Status: Found
 UCIP Comments: 06/8/2021 The record remains Non-Urgent. Both WS and LS pipe ends are heavily vegetated. Headwalls and flapgate were just barely visible, recommend removal of vegetation on both sides. No permit was found authorizing this encroachment. CVFPB will need to review crossing to determine owner. The UCIP inspection was completed with GEI staff, P. Espinoza. (H. Dunn ? GEI) 05/01/2014 Dense vegetation limits the inspector's visibility to identify signs of pipe failure (leaks) along the slope. Recommend removing vegetation along pipe alignment to conduct proper inspection of structure. (O. Magana - DWR UCIP)
 FIELD_STRUCT_DESC: 24-inch corrugated metal gravity drainage pipe (CMP) through the levee, 10.2 feet below the crown. Flap gate on the waterside (WS) end. Brass cap No. 135 bench mark (BM) on the headwall on the landside (LS). [Additional Reference(s): DWR Levee Log, 2002 (HLM 1.63). USACE San Joaquin O&M Manual, Unit No. 601, Part No. 1, 1967, Amended in 1978, Revised 20 June 1985, (HLM 1.62)].

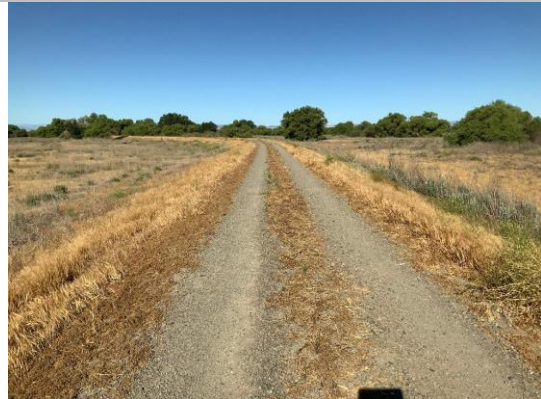
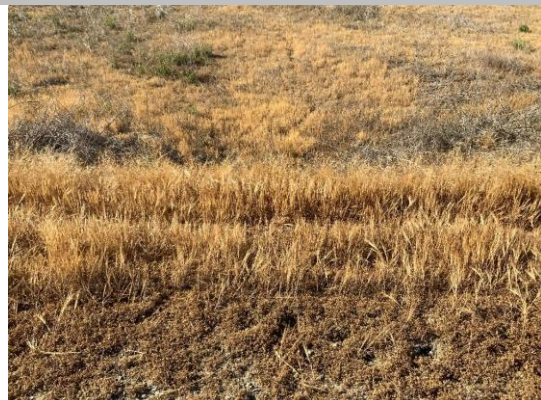
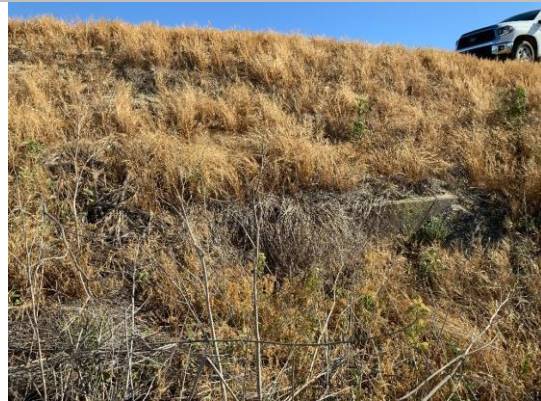
Comment Code					
Inspector Comment					
FS_ID:70939 DS_ID:19658 EP_NO: N/A Repair Type: Non-Urgent Crossing Status: Found UCIP Comments: 06/8/2021 The record remains Non-Urgent. Dense vegetation covering LS pipe inlet, recommend removal. No permit was found authorizing this encroachment. CVFPB will need to review crossing to determine owner. The UCIP inspection was completed with GEI staff, P. Espinoza. (H. Dunn ? GEI) 05/01/2014 Dense vegetation limits the inspector's visibility to identify signs of pipe failure (leaks) along the slope. Recommend removing vegetation along pipe alignment to conduct proper inspection of structure. (O. Magana - DWR UCIP) FIELD_STRUCT_DESC: 24-inch corrugated metal gravity drainage pipe (CMP) through the levee, 10.7 feet below the crown. Flap gate on the waterside (WS) end. Brass cap No. 135 bench mark (BM) on the headwall on the landside (LS). [Additional Reference(s): DWR Levee Log, 2002, (HLM 1.88). USACE San Joaquin O&M Manual, Unit No. 601, Part No. 1, 1967, Amended in 1978, Revised 20 June 1985, (HLM 1.86)]. FS Date: 6/8/2021

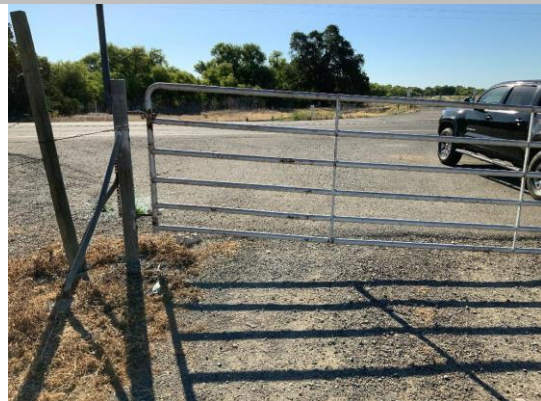
LM Start	2.28	Rating **	M	Issue No.	10 (cont)
LM End	2.28	Issue Type +	Ma	Location *	
Category	Supplemental		GPS Latitude/Longitude		
			Start	End	
Item	DWR UCIP LMA Responsibility		37.291686 °	37.291686 °	
			-120.851475 °	-120.851475 °	
DWR ID	19659

FS_ID:70940
 DS_ID:19659
 EP_NO: N/A
 Repair Type: Non-Urgent
 Crossing Status: Found
 UCIP Comments: 06/8/2021 The record remains Non-Urgent. LS pipe inlet covered by trash and debris, recommend clearing out. No permit was found authorizing this encroachment. CVFPB will need to review crossing to determine owner. The UCIP inspection was completed with GEI staff, P. Espinoza. (H. Dunn ? GEI) 05/01/2014 Dense vegetation limits the inspector's visibility to identify signs of pipe failure (leaks) along the slope. Recommend removing vegetation along pipe alignment to conduct proper inspection of structure. (O. Magana - DWR UCIP)
 FIELD_STRUCT_DESC: 24-inch corrugated metal gravity drainage pipe (CMP) through the levee, 7.0 feet below the crown. Flap gate on the waterside (WS) end. Brass cap No. 135 bench mark (BM) on the headwall on the landside (LS). [Additional Reference(s): DWR Levee Log, 2002, (HLM 2.32). USACE San Joaquin O&M Manual, Unit No. 601, Part No. 1, 1967, Amended in 1978, Revised 20 June 1985, (HLM 2.30)].

Levee crown looking upstream.

LS view: Toe from crown.

LS view: Slope from toe.
