**Flood Control Project Maintenance
Levee Inspections
LMA District Cover Sheet**

Lower San Joaquin Levee District

**Flood Control Project Maintenance
Levee Inspections
Unit Cover Sheet**

Levee Inspection Report By Mile - Spring 2022

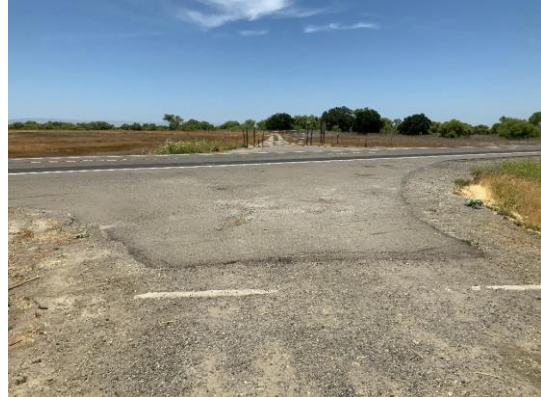
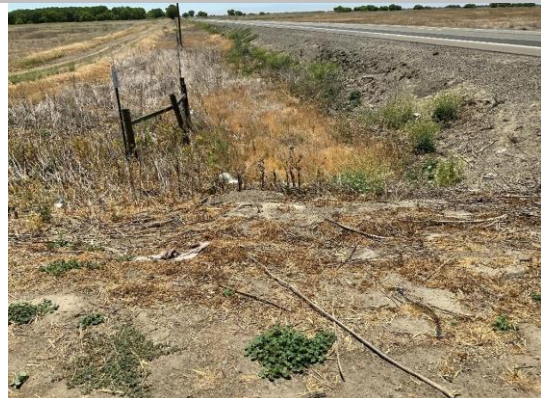
LM Start	2.30	Rating **	M	Issue No.	11 (cont)
LM End	2.30	Issue Type +	Ma	Location *

Comment Code					
Inspector Comment					
FS_ID:70941 DS_ID:19660 EP_NO: N/A Repair Type: Non-Urgent Crossing Status: Found UCIP Comments: 06/8/2021 The record remains Non-Urgent. Vegetation present at pipe inlet on LS, recommend removal. No permit was found authorizing this encroachment. CVFPB will need to review crossing to determine owner. The UCIP inspection was completed with GEI staff, P. Espinoza. (H. Dunn ? GEI) 05/01/2014 Dense vegetation limits the inspector's visibility to identify signs of pipe failure (leaks) along the slope. Recommend removing vegetation along pipe alignment to conduct proper inspection of structure. (O. Magana - DWR UCIP) FIELD_STRUCT_DESC: 24-inch corrugated metal gravity drainage pipe (CMP) through the levee, 7.0 feet below the crown. Flap gate on the waterside (WS) end. Brass cap No. 135 bench mark (BM) on the headwall on the landside (LS). [Additional Reference(s): DWR Levee Log, 2002, (HLM 2.34). USACE San Joaquin O&M Manual, Unit No. 601, Part No. 1, 1967, Amended in 1978, Revised 20 June 1985, (HLM 2.32)]. FS Date: 6/8/2021

Levee crown looking downstream.

LS view: Toe from crown.

LS view: Slope and headwall at toe.

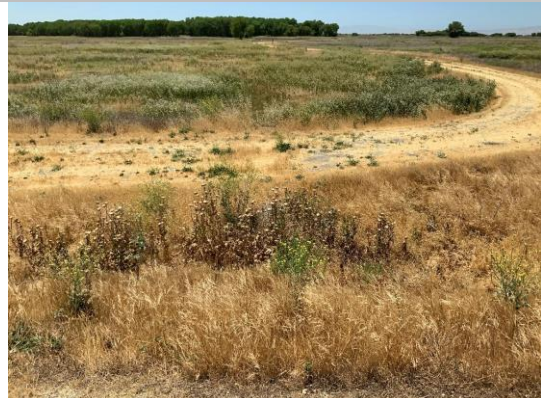
LM Start	2.58	Rating **	M	Issue No.	12 (cont)
LM End	2.58	Issue Type +	Ma	Location *

Comment Code					
Inspector Comment					
FS_ID:70942 DS_ID:19661 EP_NO: N/A Repair Type: Non-Urgent Crossing Status: Found UCIP Comments: 06/8/2021 The record remains Non-Urgent. Vegetation on LS and WS limited close up inspection of flapgate and pipe inlet. No permit was found authorizing this encroachment. CVFPB will need to review crossing to determine owner. The UCIP inspection was completed with GEI staff, P. Espinoza. (H. Dunn ? GEI) 05/01/2014 Dense vegetation limits the inspector's visibility to identify signs of pipe failure (leaks) along the slope. Recommend removing vegetation along pipe alignment to conduct proper inspection of structure. (O. Magana - DWR UCIP) FIELD_STRUCT_DESC: 24-inch corrugated metal gravity drainage pipe (CMP) through the levee, 10.0 feet below the crown. Flap gate on the waterside (WS) end. Brass cap No. 130 bench mark (BM) on the headwall on the landside (LS). [Additional Reference(s): DWR Levee Log, 2002, (HLM 2.60). USACE San Joaquin O&M Manual, Unit No. 601, Part No. 1, 1967, Amended in 1978, Revised 20 June 1985, (HLM 2.59)]. FS Date: 6/8/2021

Levee crown looking downstream.

LS view: Toe from crown.

LS view: Slope from toe.

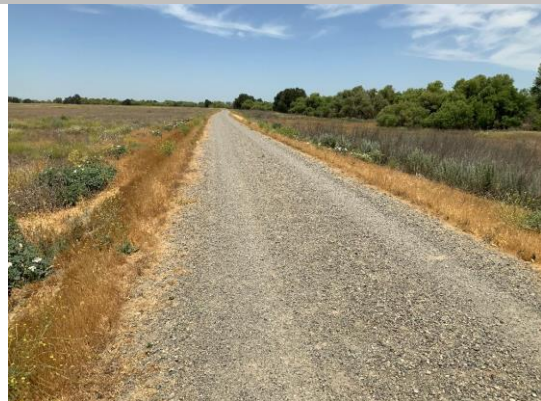
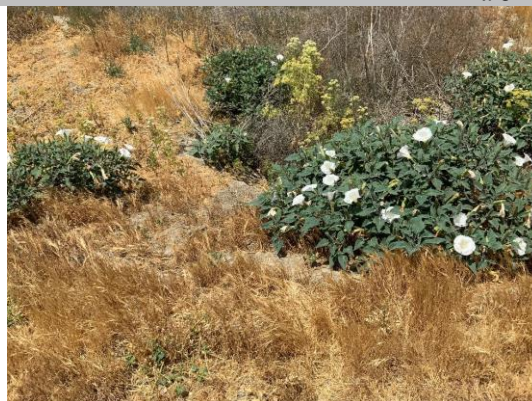
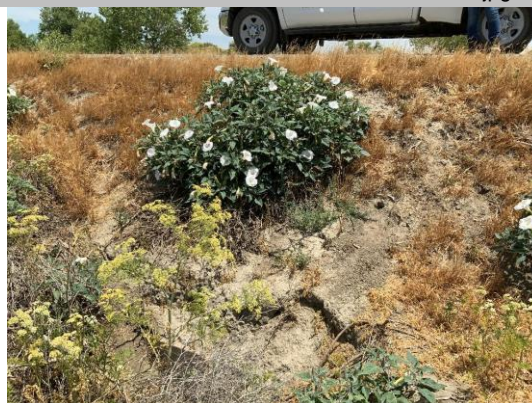
LM Start	2.95	Rating **	M	Issue No.	13
LM End	2.95	Issue Type +	Ma	Location *	
Category	Supplemental		GPS Latitude/Longitude		
			Start	End	
Item	DWR UCIP LMA Responsibility		37.284326 °	37.284326 °	
			-120.845157 °	-120.845157 °	
DWR ID	19662

FS_ID:70943
DS_ID:19662
EP_NO: N/A
Repair Type: Non-Urgent
Crossing Status: Found
UCIP Comments: 06/7/2021 The record remains Non-Urgent. LS pipe inlet completely buried in sediment, recommend clearing out. No permit was found authorizing this encroachment. CVFPB will need to review crossing to determine owner. The UCIP inspection was completed with GEI staff, P. Espinoza. (H. Dunn ? GEI) 05/01/2014 Dense vegetation limits the inspector's visibility to identify signs of pipe failure (leaks) along the slope. Recommend removing vegetation along pipe alignment to conduct proper inspection of structure. (O. Magana - DWR UCIP)
FIELD_STRUCT_DESC: 24-inch corrugated metal gravity drainage pipe (CMP) through the levee, 10.0 feet below the crown. Flap gate on the waterside (WS) end. Brass cap No. 130 bench mark (BM) on the headwall on the landside (LS). [Additional Reference(s): DWR Levee Log, 2002, (HLM 2.97). USACE San Joaquin O&M Manual, Unit No. 601, Part No. 1, 1967, Amended in 1978, Revised 20 June 1985, (HLM 2.96)].

Levee crown looking downstream.

LS view: Toe from crown.

LS view: Slope from toe.

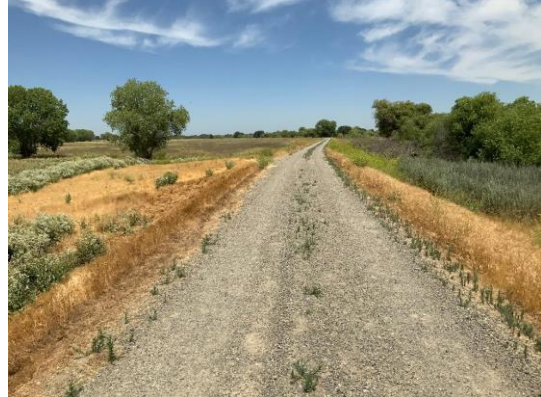
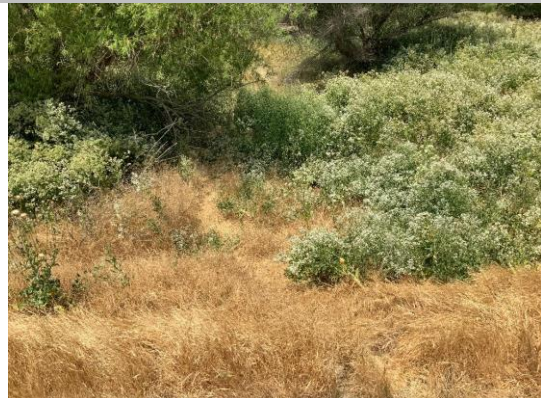
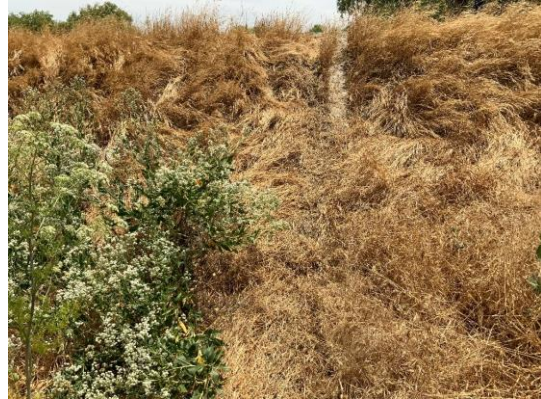
LM Start	3.28	Rating **	M	Issue No.	14 (cont)
LM End	3.28	Issue Type +	Ma	Location *

Comment Code					
Inspector Comment					
FS_ID:70944 DS_ID:19665 EP_NO: N/A Repair Type: Non-Urgent Crossing Status: Found UCIP Comments: 06/7/2021 The record remains Non-Urgent. Dense vegetation limited view and inspection of LS pipe inlet. Recommend removal of LS vegetation. No permit was found authorizing this encroachment. CVFPB will need to review crossing to determine owner. The UCIP inspection was completed with GEI staff, P. Espinoza. (H. Dunn ? GEI) 05/01/2014 Dense vegetation limits the inspector's visibility to identify signs of pipe failure (leaks) along the slope. Recommend removing vegetation along pipe alignment to conduct proper inspection of structure. (O. Magana - DWR UCIP) FIELD_STRUCT_DESC: 24-inch corrugated metal gravity drainage pipe (CMP) through the levee, 12.4 feet below the crown. Flap gate on the waterside (WS) end. Brass cap No. 130 bench mark (BM) on the headwall on the landside (LS). [Additional Reference(s): DWR Levee Log, 2002, (HLM 3.31). USACE San Joaquin O&M Manual, Unit No. 601, Part No. 1, 1967, Amended in 1978, Revised 20 June 1985, (HLM 3.29)]. FS Date: 6/7/2021

Levee crown looking downstream.

LS view: Toe from crown, pipe end not visible.

LS view: Slope from toe.

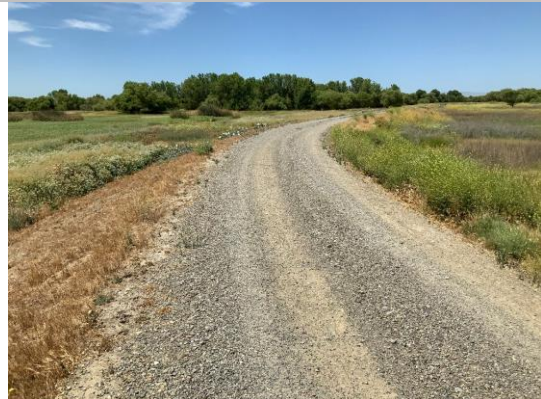
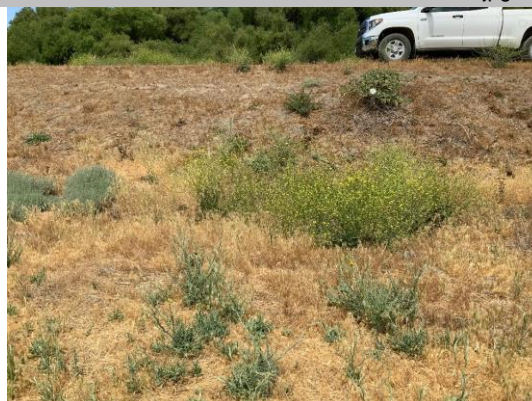
LM Start	3.61	Rating **	M	Issue No.	15
LM End	3.61	Issue Type +	Ma	Location *	
Category	Supplemental		GPS Latitude/Longitude		
			Start	End	
Item	DWR UCIP LMA Responsibility		37.278203 °	37.278203 °	
			-120.839884 °	-120.839884 °	
DWR ID	19666

UCIP Comments: 06/7/2021 The record remains Non-Urgent. LS has boards blocking the open pipe inlet but there is significant sediment and vegetation on the other side of the boards, recommend cleaning around. No permit was found authorizing this encroachment. CVFPB will need to review crossing to determine owner. The UCIP inspection was completed with GEI staff, P. Espinoza. (H. Dunn ? GEI)

05/01/2014 Dense vegetation limits the inspector's visibility to identify signs of pipe failure (leaks) along the slope. Recommend removing vegetation along pipe alignment to conduct proper inspection of structure. (O. Magana - DWR UCIP)

Levee crown looking downstream.

LS view: Toe from crown.

LS view: Slope from toe.

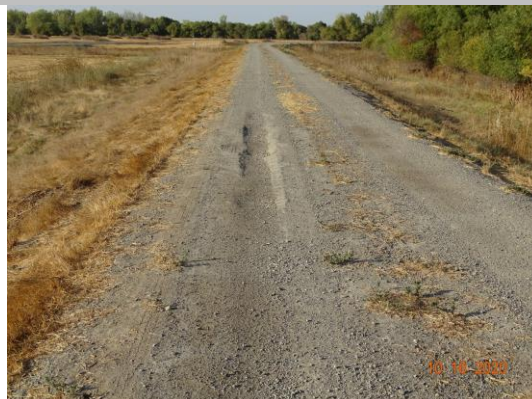
LM Start	3.69	Rating **	A/W	Issue No.	23
LM End	3.69	Issue Type +	Ma	Location *	CR
Category	Earthen Levee			GPS Latitude/Longitude	
				Start	End
Item	Crown Surface / Depressions / Rutting			37.278949 °	37.278949 °
				-120.838776 °	-120.838776 °
DWR ID	DWR_NA0010_02A_f_2020_23				
Comment Code					
C2 : Repair depressions or ruts in the crown or slope.					
Inspector Comment

Rutting along the levee crown. (Fall 2020)

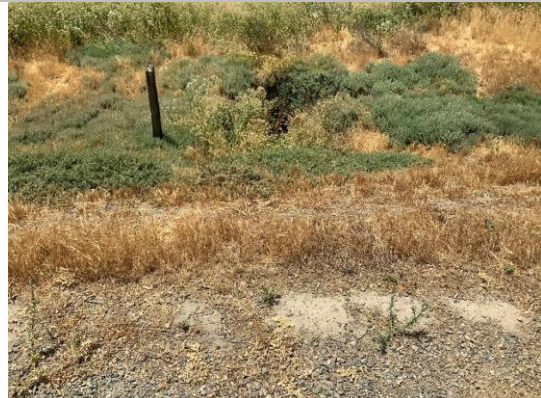
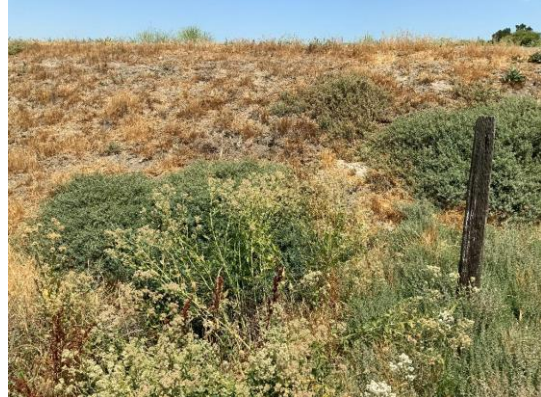
LM Start	3.94	Rating **	M	Issue No.	16 (cont)
LM End	3.94	Issue Type +	Ma	Location *

Comment Code						
Inspector Comment						
FS_ID:70946 DS_ID:19667 EP_NO: N/A Repair Type: Non-Urgent Crossing Status: Found UCIP Comments: 06/7/2021 The record remains Non-Urgent. Dense vegetation around LS pipe inlet, recommend removal. No permit was found authorizing this encroachment. CVFPB will need to review crossing to determine owner. The UCIP inspection was completed with GEI staff, P. Espinoza. (H. Dunn ? GEI) 05/01/2014 Signs of erosion or sink hole present on landward toe--Need to contact owner. Dense vegetation limits the inspector's visibility to identify signs of pipe failure (leaks) along the slope. Recommend removing vegetation along pipe alignment to conduct proper inspection of structure. (O. Magana - DWR UCIP) FIELD_STRUCT_DESC: 24-inch corrugated metal gravity drainage pipe (CMP) through the levee, 8.6 feet below the crown. Flap gate on the waterside (WS) end. Brass cap No. 130 bench mark (BM) on the headwall on the landside (LS). [Additional Reference(s): DWR Levee Log, 2002, (HLM 3.96). USACE San Joaquin O&M Manual, Unit No. 601, Part No. 1, 1967, Amended in 1978, Revised 20 June 1985, (HLM 3.95)]. FS Date: 6/7/2021

Levee crown looking downstream.

LS view: Toe from crown.

LS view: Slope from toe.

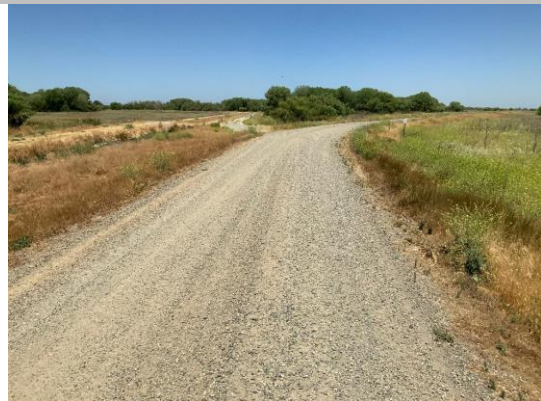
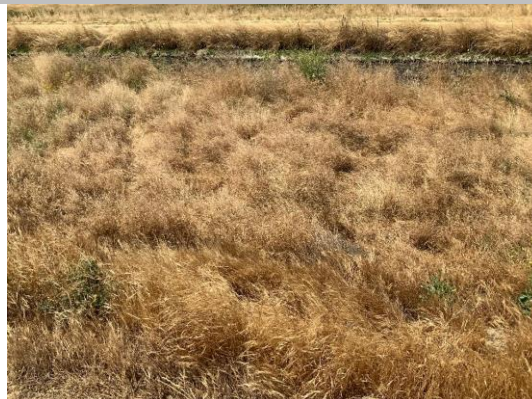
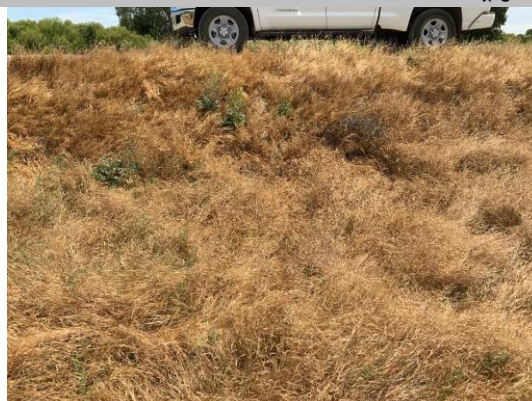
LM Start	5.41	Rating **	M	Issue No.	17
LM End	5.41	Issue Type +	Ma	Location *	
Category	Supplemental		GPS Latitude/Longitude		
			Start	End	
Item	DWR UCIP LMA Responsibility		37.260069 °	37.260069 °	
			-120.831768 °	-120.831768 °	
DWR ID	19668

FS_ID:70947
DS_ID:19668
EP_NO: N/A
Repair Type: Non-Urgent
Crossing Status: Found
UCIP Comments: 06/7/2021 The record remains Non-Urgent. Limited inspection on WS due to dense vegetation, flapgate not visible, recommend clearing away. Limited inspection on LS due to canal limiting access to inlet. No permit was found authorizing this encroachment. CVFPB will need to review crossing to determine owner. The UCIP inspection was completed with GEI staff, P. Espinoza. (H. Dunn ? GEI) 05/01/2014 Dense vegetation limits the inspector's visibility to identify signs of pipe failure (leaks) along the slope. Recommend removing vegetation along pipe alignment to conduct proper inspection of structure. (O. Magana - DWR UCIP)
FIELD_STRUCT_DESC: 24-inch corrugated metal gravity drainage pipe (CMP) through the levee, 8.0 feet below the crown. Flap gate on the waterside (WS) end. Brass cap No. 125 bench mark (BM) on the headwall on the landside (LS). [Additional Reference(s): DWR Levee Log, 2002, (HLM 5.45). USACE San Joaquin O&M Manual, Unit No. 601, Part No. 1, 1967, Amended in 1978, Revised 20 June 1985, (HLM 5.43)].

Levee crown looking downstream.

LS view: Toe from crown.

LS view: Slope from toe.

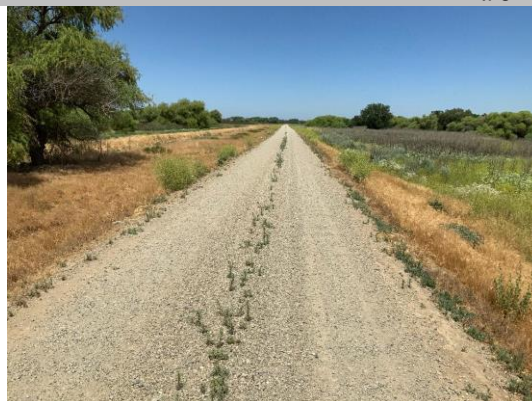
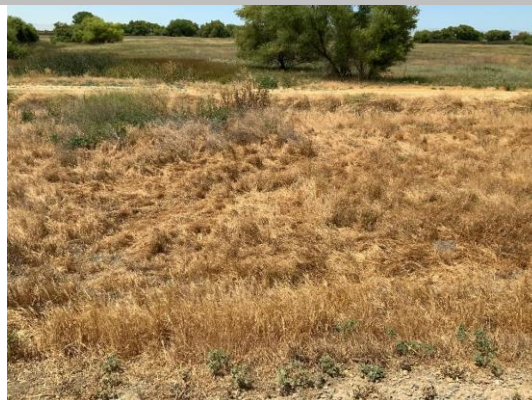
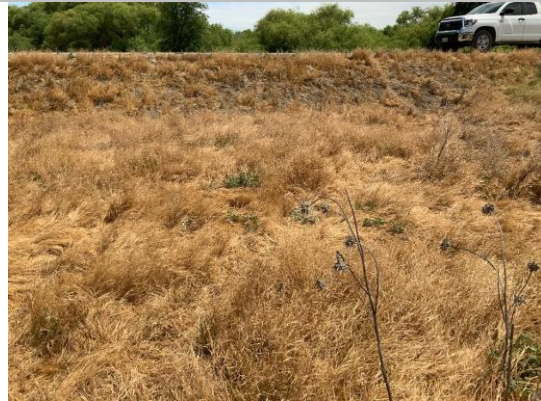
LM Start	6.03	Rating **	M	Issue No.	18 (cont)
LM End	6.03	Issue Type +	Ma	Location *

FS_ID:70948
DS_ID:19669
EP_NO: N/A
Repair Type: Non-Urgent
Crossing Status: Found
UCIP Comments: 06/7/2021 The record remains Non-Urgent. LS pipe inlet completely buried under sediment, recommend clearing out. No permit was found authorizing this encroachment. CVFPB will need to review crossing to determine owner. The UCIP inspection was completed with GEI staff, P. Espinoza. (H. Dunn ? GEI) 05/01/2014 Dense vegetation limits the inspector's visibility to identify signs of pipe failure (leaks) along the slope. Recommend removing vegetation along pipe alignment to conduct proper inspection of structure. (O. Magana - DWR UCIP)
FIELD_STRUCT_DESC: 24-inch corrugated metal gravity drainage pipe (CMP) through the levee, 7.7 feet below the crown. Flap gate on the waterside (WS) end. Brass cap No. 125 bench mark (BM) on the headwall on the landside (LS). [Additional Reference(s): DWR Levee Log, 2002, (HLM 6.06). USACE San Joaquin O&M Manual, Unit No. 601, Part No. 1, 1967, Amended in 1978, Revised 20 June 1985, (HLM 6.06)].

Levee crown looking downstream.

LS view: Toe from crown.

LS view: Slope from toe.

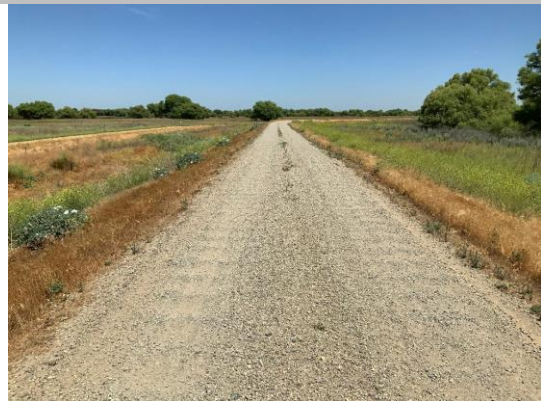
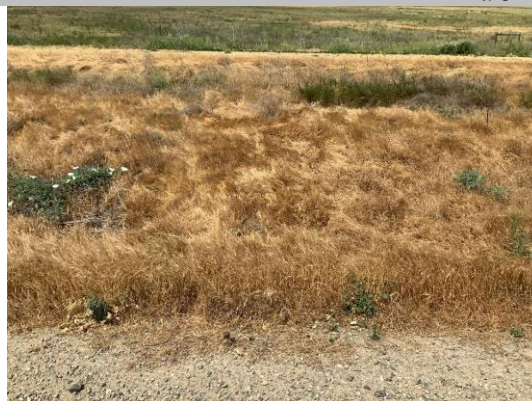
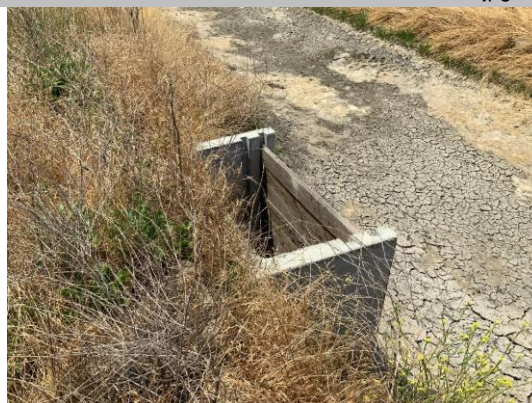
LM Start	6.47	Rating **	M	Issue No.	19
LM End	6.47	Issue Type +	Ma	Location *	
Category	Supplemental		GPS Latitude/Longitude		
			Start	End	
Item	DWR UCIP LMA Responsibility		37.248210 °	37.248210 °	
			-120.823120 °	-120.823120 °	
DWR ID	19670

FS_ID:70949
DS_ID:19670
EP_NO: N/A
Repair Type: Non-Urgent
Crossing Status: Found
UCIP Comments: 06/7/2021 The record remains Non-Urgent. Limited inspection on LS due to canal and inability to access. No permit was found authorizing this encroachment. CVFPB will need to review crossing to determine owner. The UCIP inspection was completed with GEI staff, P. Espinoza. (H. Dunn ? GEI) 05/01/2014 Dense vegetation limits the inspector's visibility to identify signs of pipe failure (leaks) along the slope. Recommend removing vegetation along pipe alignment to conduct proper inspection of structure. (O. Magana - DWR UCIP)
FIELD_STRUCT_DESC: 24-inch corrugated metal gravity drainage pipe (CMP) through the levee, 7.7 feet below the crown. Flap gate on the waterside (WS) end. Brass cap No. 125 bench mark (BM) on the headwall on the landside (LS). [Additional Reference(s): DWR Levee Log, 2002, (HLM 6.50). USACE San Joaquin O&M Manual, Unit No. 601, Part No. 1, 1967, Amended in 1978, Revised 20 June 1985, (HLM 6.50)].

Levee crown looking downstream.

LS view: Toe from crown.

LS view: Close up of concrete box and pipe inlet.

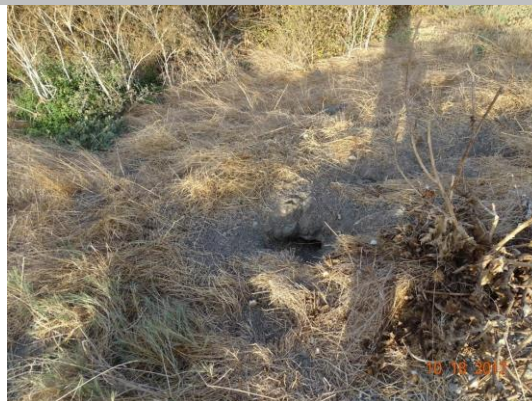
Photo 1 of 1 : SP_2022_NA0010_119_28_20220308_00008.jpg

LM Start	6.97	Rating **	A/W	Issue No.	28
LM End	6.97	Issue Type +	Ma	Location *	LS
Category	Earthen Levee			GPS Latitude/Longitude	
				Start	End
Item	Animal Control			37.241125 °	37.241125 °
				-120.821747 °	-120.821747 °
DWR ID	DWR_NA0010_02A_f_2017_28				
Comment Code					
A3 : No rodents visible, but rodent burrows visible; need to backfill and compact or grout burrows.					
Inspector Comment

Looking northwest at landside slope.

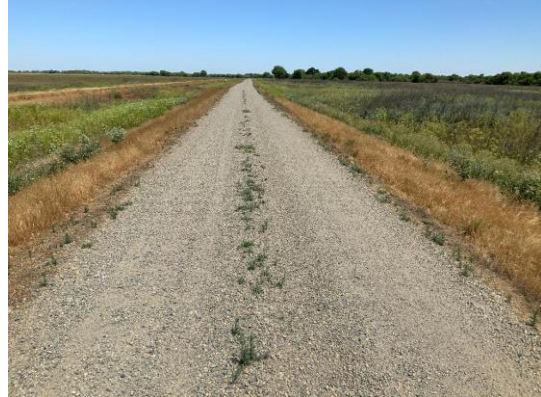
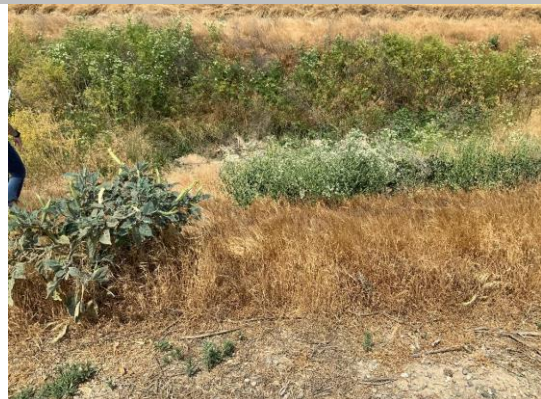
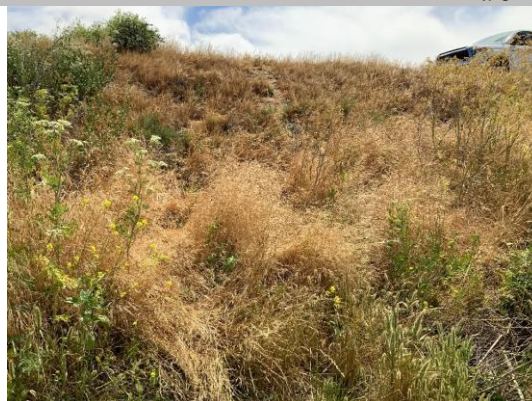
Photo 1 of 3 : UCIP_SP_2022_70950_100180.jpg

Comment Code						
Inspector Comment						
FS_ID:70950 DS_ID:19671 EP_NO: N/A Repair Type: Non-Urgent Crossing Status: Found UCIP Comments: 06/7/2021 The record remains Non-Urgent. Dense vegetation on WS limited inspection. LS pipe inlet is completely buried under sediment, recommend cleaning out. No permit was found authorizing this encroachment. CVFPB will need to review crossing to determine owner. The UCIP inspection was completed with GEI staff, P. Espinoza. (H. Dunn ? GEI) 05/01/2014 Dense vegetation limits the inspector's visibility to identify signs of pipe failure (leaks) along the slope. Recommend removing vegetation along pipe alignment to conduct proper inspection of structure. Pipe extension visible on landward side--need to contact owner for additional information about extension/modification. (O. Magana - DWR UCIP) FIELD_STRUCT_DESC: 24-inch corrugated metal gravity drainage pipe (CMP) through the levee, 12.6 feet below the crown. Flap gate on the waterside (WS) end. Brass cap No. 125 bench mark (BM) on the headwall on the landside (LS). [Additional Reference(s): DWR Levee Log, 2002, (HLM 7.06). USACE San Joaquin O&M Manual, Unit No. 601, Part No. 1, 1967, Amended in 1978, Revised 20 June 1985, (HLM 7.05)]. FS Date: 6/7/2021

Levee crown looking downstream.

LS view: Toe from crown.

LS view: Slope from toe.

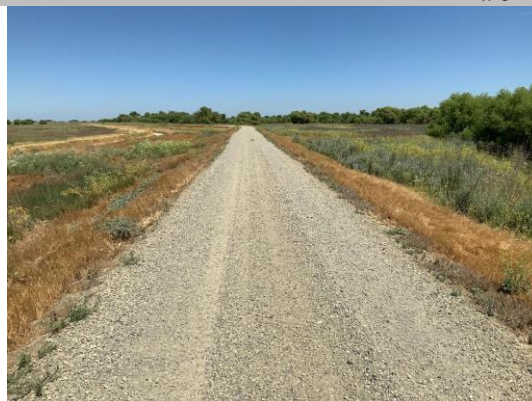
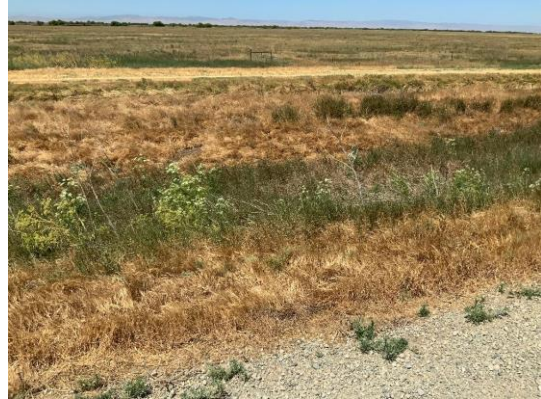
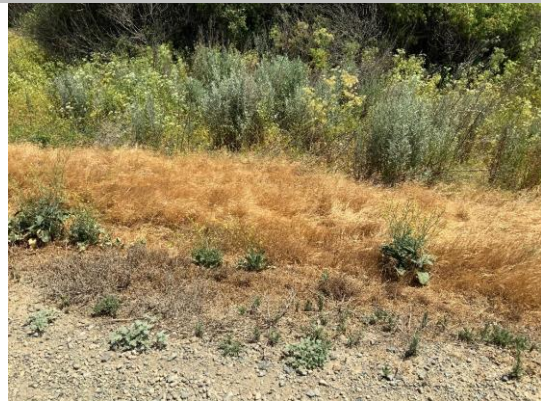
Photo 1 of 3 : UCIP_SP_2022_70951_100185.jpg

FS_ID:70951
DS_ID:19672
EP_NO: N/A
Repair Type: Non-Urgent
Crossing Status: Not Found
UCIP Comments: 06/7/2021 The record is Non-Urgent. Pipe not found by visual inspection. No permit was found authorizing this encroachment. CVFPB will need to review crossing to determine owner. The UCIP inspection was completed with GEI staff, P. Espinoza. (H. Dunn ? GEI)
FIELD_STRUCT_DESC: 4-inch aluminum pipe of an unknown purpose through the levee, 0.333 feet below the crown. [Additional Resource(s): DWR Levee Logs, 2002, (HLM 7.48)].
FS Date: 6/7/2021

Levee crown looking downstream.

LS view: Toe from crown, no pipe visible.

WS view: Toe from crown, no pipe visible.

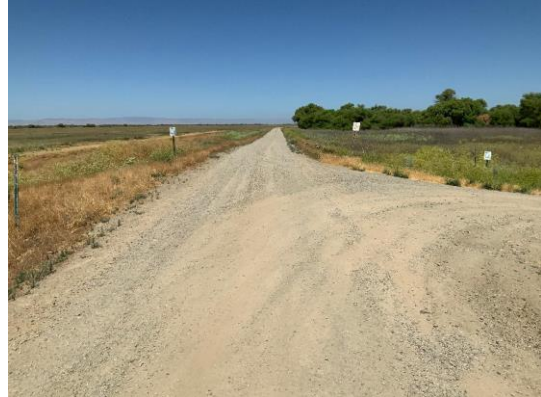
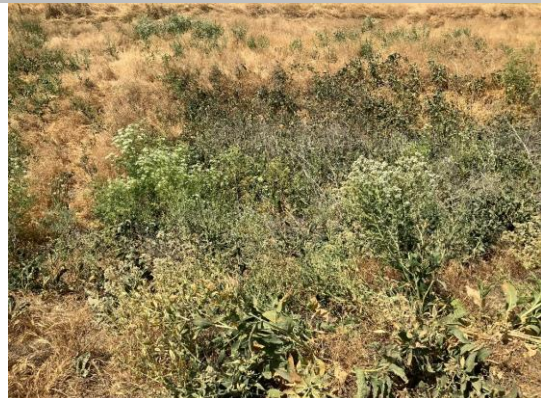
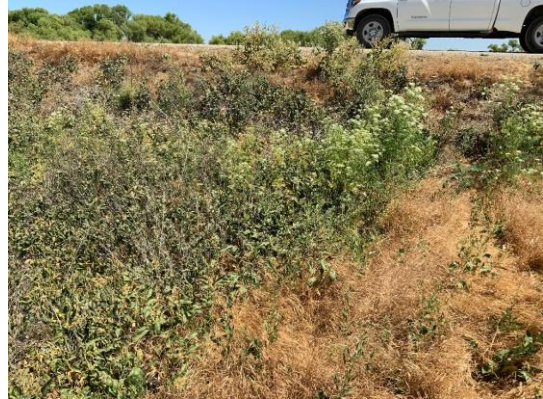
Photo 1 of 3 : UCIP_SP_2022_70952_100189.jpg

Comment Code					
Inspector Comment					
FS_ID:70952 DS_ID:19673 EP_NO: N/A Repair Type: Non-Urgent Crossing Status: Found UCIP Comments: 06/7/2021 The record remains Non-Urgent. LS pipe end not visible, dense vegetation on both WS and LS ends, recommend removal. No permit was found authorizing this encroachment. CVFPB will need to review crossing to determine owner. The UCIP inspection was completed with GEI staff, P. Espinoza. (H. Dunn ? GEI)05/01/2014 Dense vegetation limits the inspector's visibility to identify signs of pipe failure (leaks) along the slope. Recommend removing vegetation along pipe alignment to conduct proper inspection of structure. (O. Magana - DWR UCIP) FIELD_STRUCT_DESC: 24-inch corrugated metal gravity drainage pipe (CMP) through the levee, 8.0 feet below the crown. Flap gate on the waterside (WS) end. Brass cap No. 125 bench mark (BM) on the headwall on the landside (LS). [Additional Reference(s): DWR Levee Log, 2002, (HLM 7.78). USACE San Joaquin O&M Manual, Unit No. 601, Part No. 1, 1967, Amended in 1978, Revised 20 June 1985, (HLM 7.77)]. FS Date: 6/7/2021

Levee crown looking downstream.

LS view: Headwall and inlet not visible under vegetation.

LS view: Slope from toe.

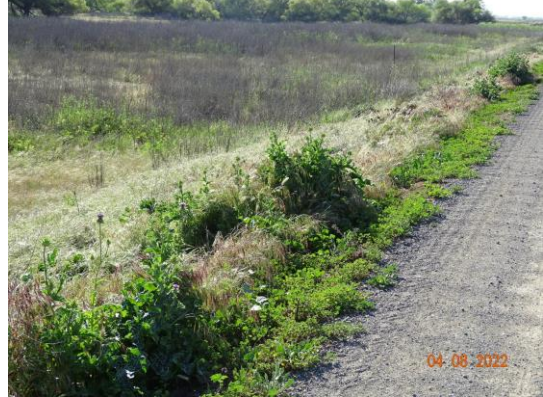
Photo 1 of 1 : SP_2022_NA0010_120_16_20220412_00049.jpg

LM Start	7.87	Rating **	M	Issue No.	16
LM End	11.16	Issue Type +	Ma	Location *	WS
Category	Earthen Levee			GPS Latitude/Longitude	
				Start	End
Item	Vegetation			37.231246 °	37.204359 °
				-120.811818 °	-120.771238 °
DWR ID	DWR_NA0010_02B_s _ 2022_16				
Comment Code					
V1 : Control annual grass and weeds on the levee slopes and easements.					
Inspector Comment

Looking upstream along the waterside slope. (Spring 2022)

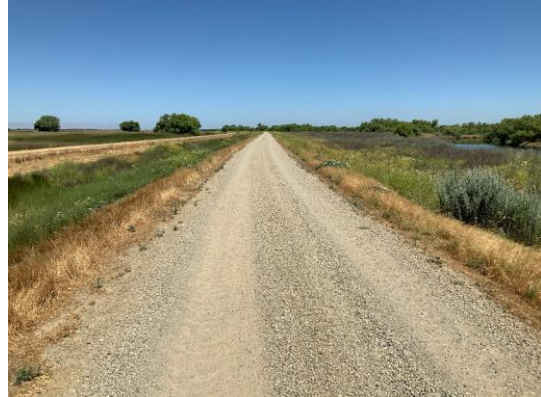
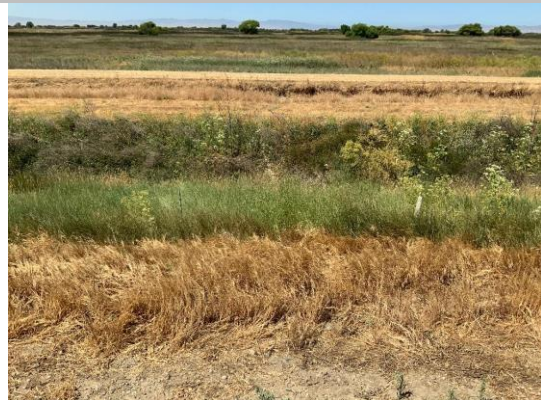
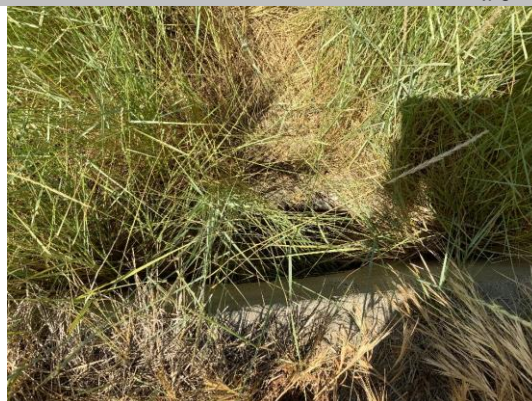
Photo 1 of 3 : UCIP_SP_2022_70953_100048.jpg

Comment Code						
Inspector Comment						
FS_ID:70953 DS_ID:19674 EP_NO: N/A Repair Type: Non-Urgent Crossing Status: Found UCIP Comments: 06/7/2021 Record remains Non-Urgent. DWR DMP internal inspection has not found pipe integrity issues. LOF of crossing is less or equal to 4.0. Recommend next video inspection in 5 years. LS headwall barely visible at toe due to dense vegetation. Dense vegetation also over WS flapgate. Limited inspection of both WS and LS pipe ends. Recommend removal of vegetation on both WS and LS. No permit was found authorizing this encroachment. CVFPB will need to review crossing to determine owner. The UCIP inspection was completed with GEI staff, P. Espinoza. (H. Dunn ? GEI) 05/14/2014 Dense vegetation limits the inspector's visibility to identify signs of pipe failure (leaks) along the slope and landward headwall. Recommend removing vegetation along pipe alignment and toe to conduct proper inspection of structure. Sediment buildup in pipe visible from landward side--recommend clearing. (O. Magana - DWR UCIP) FIELD_STRUCT_DESC: 24-inch corrugated metal gravity drainage pipe (CMP) through the levee, 9.0 feet below the crown. Flap gate on the waterside (WS) end. Brass cap No. 120 bench mark (BM) on the headwall on the landside (LS). [Additional Reference(s): DWR Levee Log, 2002, (HLM 8.17). USACE San Joaquin O&M Manual, Unit No. 601, Part No. 1, 1967, Amended in 1978, Revised 20 June 1985, (HLM 8.16)]. FS Date: 6/7/2021

Levee crown looking downstream.

LS view: Slope from crown.

LS view: Headwall barely visible at toe.

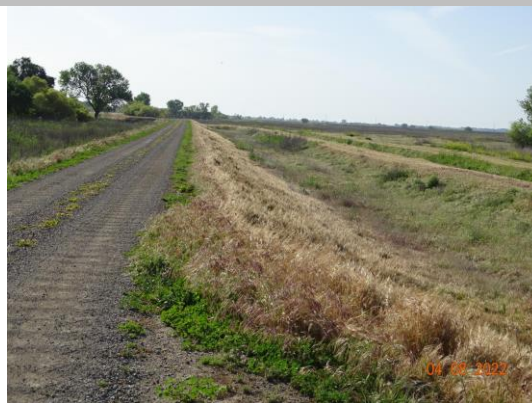
Photo 1 of 1 : SP_2022_NA0010_120_17_20220412_00050.jpg

LM Start	8.31	Rating **	M	Issue No.	17
LM End	11.16	Issue Type +	Ma	Location *	LS
Category	Earthen Levee			GPS Latitude/Longitude	
				Start	End
Item	Vegetation			37.226588 °	37.204391 °
				-120.806307 °	-120.771274 °
DWR ID	DWR_NA0010_02B_s_2022_17				
Comment Code					
V1 : Control annual grass and weeds on the levee slopes and easements.					
Inspector Comment

View of vegetation on the landside slope. (Spring 2022)

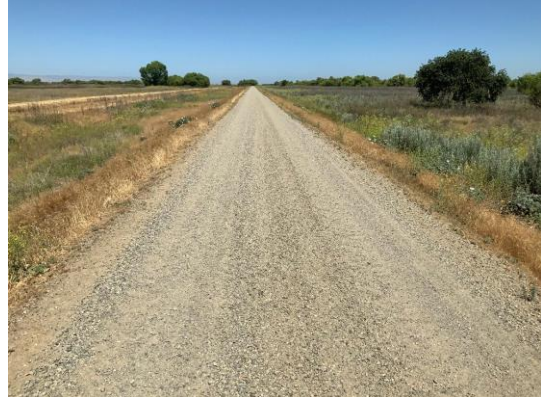
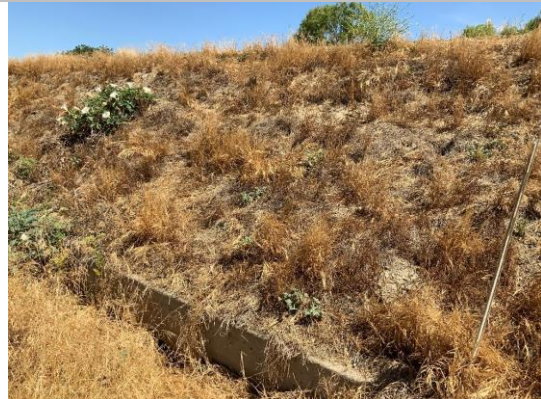
Photo 1 of 3 : UCIP_SP_2022_70954_100340.jpg

Comment Code						
Inspector Comment						
FS_ID:70954 DS_ID:19675 EP_NO: N/A Repair Type: Non-Urgent Crossing Status: Found UCIP Comments: 06/7/2021 The record remains Non-Urgent. LS pipe inlet completely buried in dense vegetation, only top of headwall visible. Dense vegetation above WS flapgate. Limited inspection of pipe ends, recommend vegetation removal on both sides. No permit was found authorizing this encroachment. CVFPB will need to review crossing to determine owner. The UCIP inspection was completed with GEI staff, P. Espinoza. (H. Dunn ? GEI) 05/14/2014 Dense vegetation on landward toe. Also dense vegetation limits the inspector's visibility to identify signs of pipe failure (leaks) along waterward slope. Recommend removing vegetation along pipe alignment toe to conduct proper inspection of structure. Sediment buildup in pipe--recommend clearing. (O. Magana - DWR UCIP) FIELD_STRUCT_DESC: 24-inch corrugated metal gravity drainage pipe (CMP) through the levee, 9.4 feet below the crown. Flap gate on the waterside (WS) end. Brass cap No. 120 bench mark (BM) on the headwall on the landside (LS). [Additional Reference(s): DWR Levee Log, 2002, (HLM 8.49). USACE San Joaquin O&M Manual, Unit No. 601, Part No. 1, 1967, Amended in 1978, Revised 20 June 1985, (HLM 8.48)]. FS Date: 6/7/2021

Levee crown looking downstream.

LS view: Toe and slope from crown.

LS view: Slope from toe, top of headwall visible.

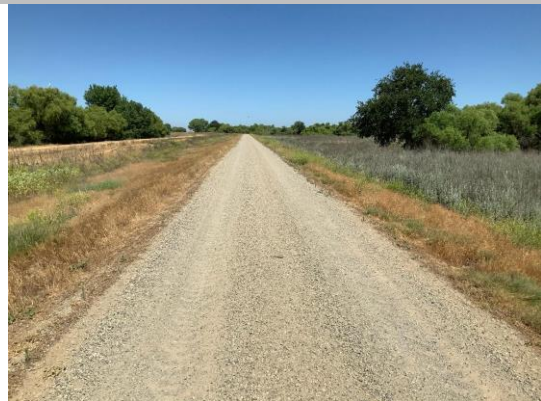
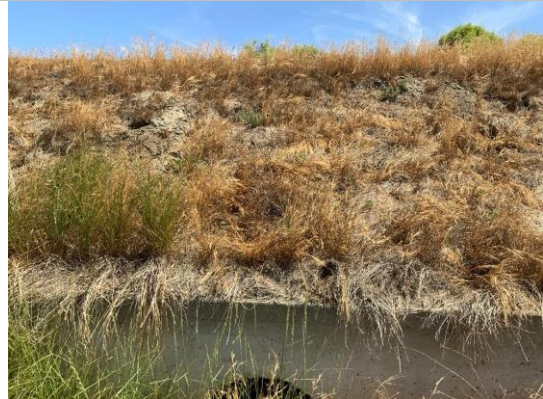
Photo 1 of 3 : UCIP_SP_2022_70955_100347.jpg

FS_ID:70955
DS_ID:19676
EP_NO: N/A
Repair Type: Non-Urgent
Crossing Status: Found
UCIP Comments: 06/7/2021 The record remains Non-Urgent. DWR DMP internal inspection has not found pipe integrity issues. LOF of crossing is less or equal to 4.0. Recommend next video inspection in 5 years. Dense vegetation around LS pipe end, recommend removal. No permit was found authorizing this encroachment. CVFPB will need to review crossing to determine owner. The UCIP inspection was completed with GEI staff, P. Espinoza. (H. Dunn ? GEI) 05/14/2014 Dense vegetation limits the inspector's visibility to identify signs of pipe failure (leaks) along the slope. Recommend removing vegetation along pipe alignment to conduct proper inspection of structure. Burrow activity present on waterward slope. (O. Magana - DWR UCIP)
FIELD_STRUCT_DESC: 24-inch corrugated metal gravity drainage pipe (CMP) through the levee, 8.8 feet below the crown. Flap gate on the waterside (WS) end. Brass cap No. 120 bench mark (BM) on the headwall on the landside (LS). [Additional Reference(s): DWR Levee Log, 2002, (HLM 8.88). USACE San Joaquin O&M Manual, Unit No. 601, Part No. 1, 1967, Amended in 1978, Revised 20 June 1985, (recorded as HLM 9.86, should be HLM 8.86)].

Levee crown looking downstream.

LS view: Toe from crown.

LS view: Slope above headwall from toe.

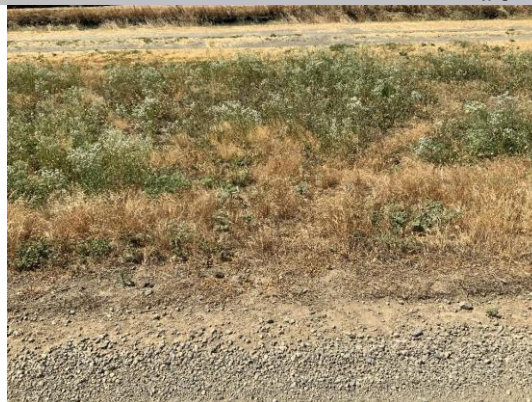
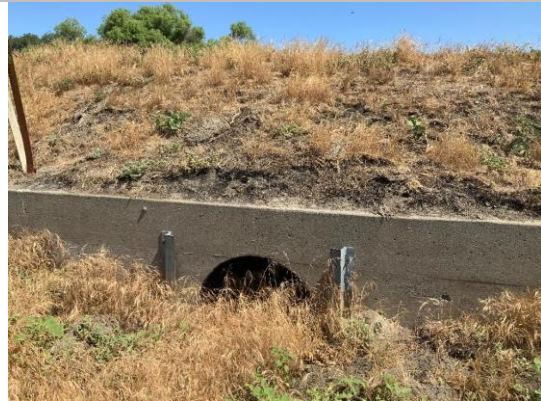
Photo 1 of 3 : UCIP_SP_2022_70956_100353.jpg

Comment Code						
Inspector Comment						
FS_ID:70956 DS_ID:19677 EP_NO: N/A Repair Type: Non-Urgent Crossing Status: Found UCIP Comments: 06/7/2021 The record remains Non-Urgent. No permit was found authorizing this encroachment. CVFPB will need to review crossing to determine owner. Minor vegetation over LS pipe inlet. The UCIP inspection was completed with GEI staff, P. Espinoza. (H. Dunn ? GEI) 05/14/201 Dense vegetation limits the inspector's visibility to identify signs of pipe failure (leaks) along the slope. Recommend removing vegetation along pipe alignment to conduct proper inspection of structure. (O. Magana - DWR UCIP) FIELD_STRUCT_DESC: 36-inch corrugated metal gravity drainage pipe (CMP) through the levee, 8.8 feet below the crown. Flap gate on the waterside (WS) end. Brass cap No. 120 bench mark (BM) on the headwall on the landside (LS). [Additional Reference(s): DWR Levee Log, 2002, (HLM 9.03). USACE San Joaquin O&M Manual, Unit No. 601, Part No. 1, 1967, Amended in 1978, Revised 20 June 1985, (HLM 9.02)]. FS Date: 6/7/2021

Levee crown looking downstream.

LS view: Toe from crown.

LS view: Slope and headwall at toe.

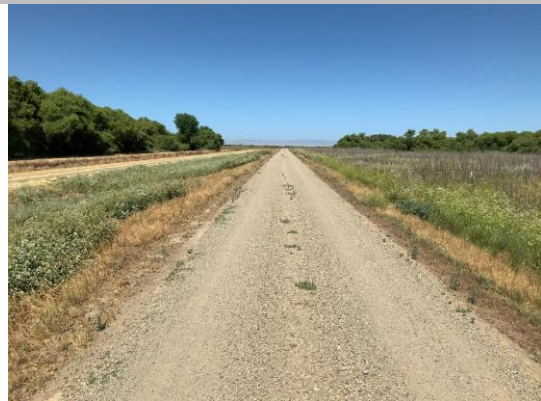
Photo 1 of 3 : UCIP_SP_2022_70957_100361.jpg

FS_ID:70957
DS_ID:19678
EP_NO: N/A
Repair Type: Non-Urgent
Crossing Status: Found
UCIP Comments: 06/7/2021 The record remains Non-Urgent. DWR DMP internal inspection has not found pipe integrity issues. LOF of crossing is less or equal to 4.0. Recommend next video inspection in 5 years. Dense vegetation over LS pipe inlet limited inspection, recommend removal. No permit was found authorizing this encroachment. CVFPB will need to review crossing to determine owner. The UCIP inspection was completed with GEI staff, P. Espinoza. (H. Dunn ? GEI) 05/14/2014 Dense vegetation limits the inspector's visibility to identify signs of pipe failure (leaks) along the slope. Recommend removing vegetation along pipe alignment to conduct proper inspection of structure. (O. Magana - DWR UCIP)
FIELD_STRUCT_DESC: 24-inch corrugated metal gravity drainage pipe (CMP) through the levee, 8.0 feet below the crown. Flap gate on the waterside (WS) end. Brass cap No. 120 bench mark (BM) on the headwall on the landside (LS). [Additional Reference(s): DWR Levee Log, 2002, (HLM 9.21). USACE San Joaquin O&M Manual, Unit No. 601, Part No. 1, 1967, Amended in 1978, Revised 20 June 1985, (HLM 9.20)].

Levee crown looking downstream.

LS view: Toe from crown.

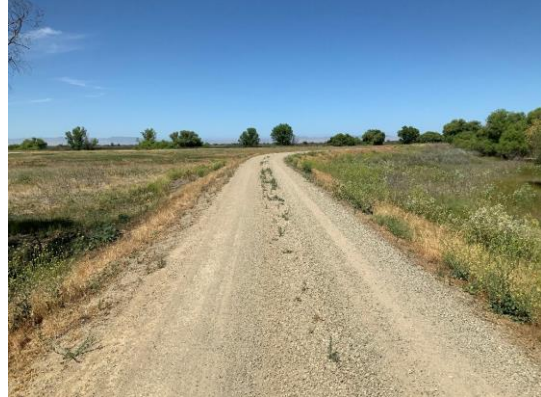
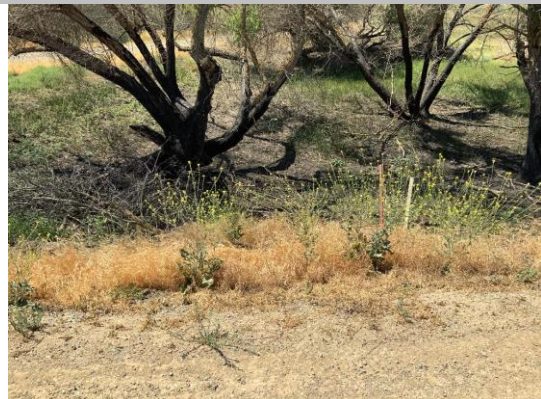
Photo 1 of 3 : UCIP_SP_2022_70958_100369.jpg

Comment Code					
Inspector Comment					
FS_ID:70958 DS_ID:19686 EP_NO: N/A Repair Type: Urgent Crossing Status: Found UCIP Comments: 06/7/2021 The record has been upgraded from Non-Urgent to Urgent. DWR DMP internal inspection has found pipe integrity issues. LOF of crossing is greater than or equal to 5.0. Crossing will be monitored until funding becomes available to address the issues. Some rusting and peeling of liner inside LS pipe inlet. No permit was found authorizing this encroachment. CVFPB will need to review crossing to determine owner. The UCIP inspection was completed with GEI staff, P. Espinoza. (H. Dunn ? GEI)05/14/2014 Dense vegetation limits the inspector's visibility to identify signs of pipe failure (leaks) along the slope. Recommend removing vegetation along pipe alignment to conduct proper inspection of structure. (O. Magana - DWR UCIP) FIELD_STRUCT_DESC: 24-inch corrugated metal gravity drainage pipe (CMP) through the levee, 9.0 feet below the crown. Flap gate on the waterside (WS) end. Brass cap No. 115 bench mark (BM) on the headwall on the landside (LS). [Additional Reference(s): DWR Levee Log, 2002, (HLM 9.47). USACE San Joaquin O&M Manual, Unit No. 601, Part No. 1, 1967, Amended in 1978, Revised 20 June 1985, (HLM 9.46)]. FS Date: 6/7/2021

Levee crown looking downstream.

LS view: Toe from crown.

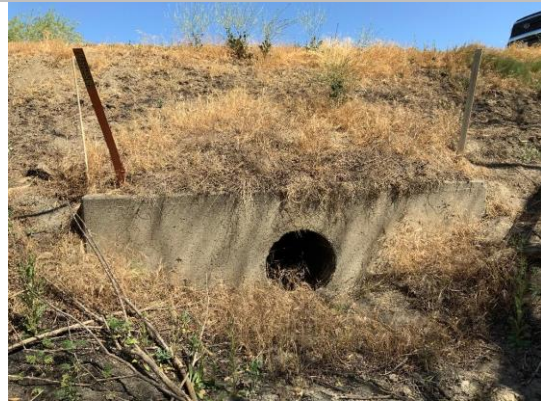
Photo 3 of 3 : UCIP_SP_2022_70958_100371.jpg

LS view: Slope and headwall at toe.

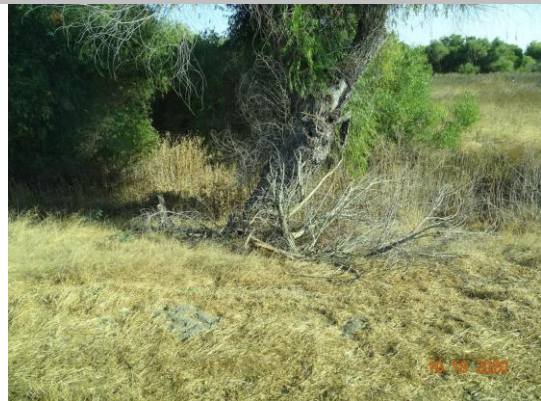
Photo 1 of 1 : SP_2022_NA0010_120_15_20220308_00003.jpg

LM Start	9.60	Rating **	M	Issue No.	15
LM End	9.60	Issue Type +	Ma	Location *	WS
Category	Earthen Levee			GPS Latitude/Longitude	
				Start	End
Item	Encroachments			37.220783 °	37.220783 °
				-120.785729 °	-120.785729 °
DWR ID	DWR_NA0010_02B_f_2020_15				
Comment Code					
TR : Tree or limb					
Inspector Comment					
Broken tree limbs on the waterside slope.

Tree limb on the waterside slope. (Fall 2020)

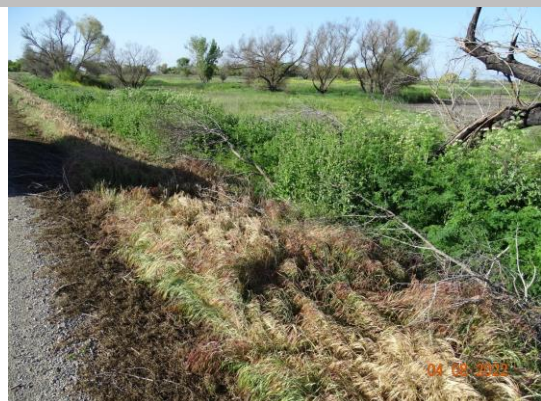
Photo 1 of 1 : SP_2022_NA0010_120_18_20220412_00051.jpg

LM Start	9.85	Rating **	M	Issue No.	18
LM End	9.85	Issue Type +	Ma	Location *	LS
Category	Earthen Levee			GPS Latitude/Longitude	
				Start	End
Item	Trim / Thin Trees			37.217702 °	37.217702 °
				-120.784130 °	-120.784130 °
DWR ID	DWR_NA0010_02B_s_2022_18				
Comment Code					
T6 : Trees / Falling Tree.					
Inspector Comment

Fallen tree branches on the landside slope. (Spring 2022)

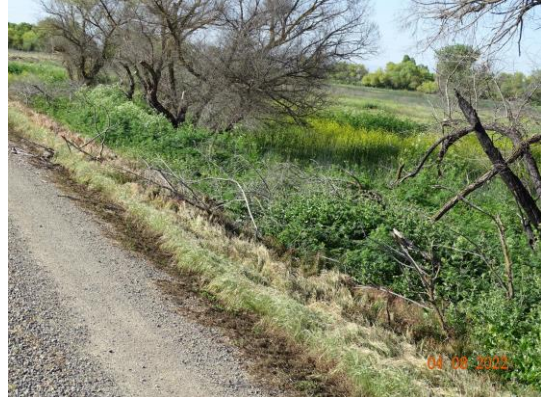
Photo 1 of 1 : SP_2022_NA0010_120_19_20220412_00052.jpg

LM Start	9.90	Rating **	M	Issue No.	19
LM End	9.90	Issue Type +	Ma	Location *	LS
Category	Earthen Levee			GPS Latitude/Longitude	
				Start	End
Item	Trim / Thin Trees			37.217010 °	37.217010 °
				-120.784018 °	-120.784018 °
DWR ID	DWR_NA0010_02B_s_2022_19				
Comment Code					
T6 : Trees / Falling Tree.					
Inspector Comment

View of tree limbs fallen on the landside toe. (Spring 2020)

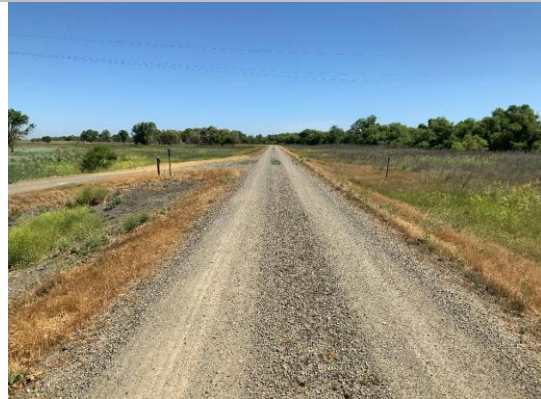
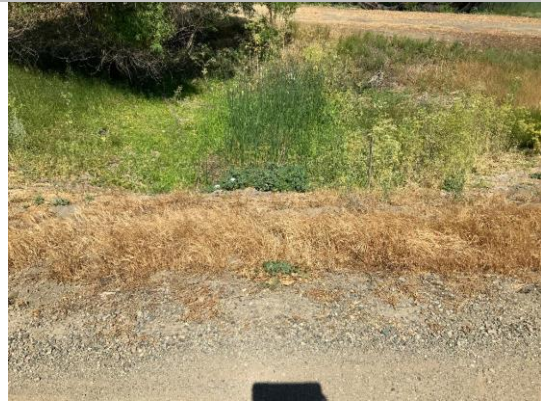
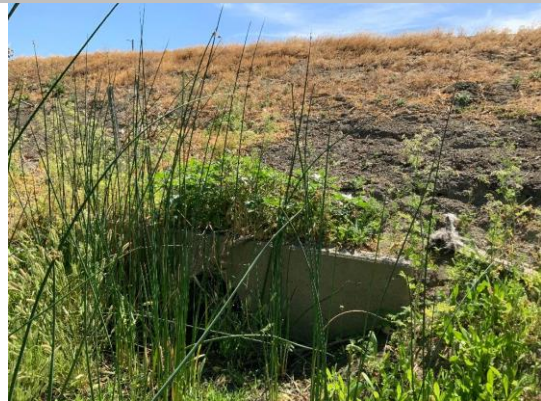
Comment Code						
Inspector Comment						
FS_ID:70959						
DS_ID:19687						
EP_NO: N/A						
Repair Type: Non-Urgent						
Crossing Status: Found						
UCIP Comments: 06/7/2021 The record remains Non-Urgent. Some sediment buildup inside LS pipe inlet. LS pipe inlet also covered by some vegetation. Recommend cleaning out sediment and removing vegetation. WS flapgate partially underwater and covered by vegetation, limited inspection of both WS and LS. No permit was found authorizing this encroachment. CVFPB will need to review crossing to determine owner. The UCIP inspection was completed with GEI staff, P. Espinoza. (H. Dunn- GEI) 05/14/2014 Dense vegetation limits the inspector's visibility to identify signs of pipe failure (leaks) along the slope. Recommend removing vegetation along pipe alignment to conduct proper inspection of structure. (O. Magana - DWR UCIP)						
FIELD_STRUCT_DESC: 24-inch corrugated metal gravity drainage pipe (CMP) through the levee, 11.7 feet below the crown. Flap gate on the waterside (WS) end. Brass cap No. 115 bench mark (BM) on the headwall on the landside (LS). [Additional Reference(s): DWR Levee Log, 2002, (HLM 10.13). USACE San Joaquin O&M Manual, Unit No. 601, Part No. 1, 1967, Amended in 1978, Revised 20 June 1985, (HLM 10.12)].

LS view: Toe from crown.

LS view: Slope and headwall from toe.

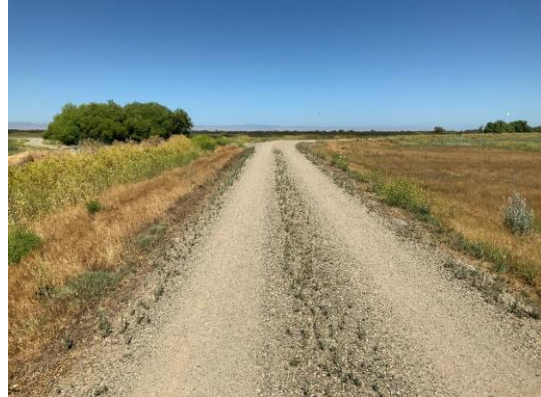
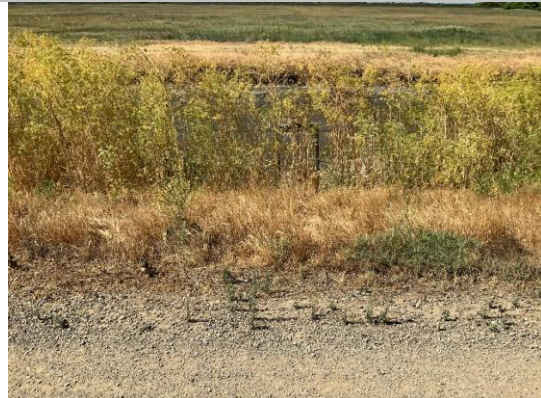
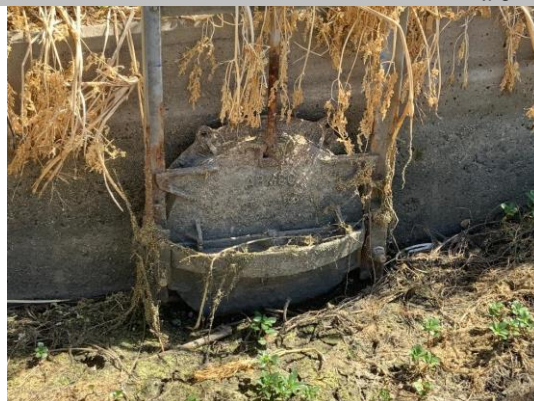
Comment Code						
Inspector Comment						
FS_ID:70960 DS_ID:19688 EP_NO: N/A Repair Type: Non-Urgent Crossing Status: Found UCIP Comments: 06/7/2021 The record remains Non-Urgent. WS end and flapgate is overgrown with dense vegetation limiting inspection, recommend removal. No permit was found authorizing this encroachment. CVFPB will need to review crossing to determine owner. The UCIP inspection was completed with GEI staff, P. Espinoza. (H. Dunn ? GEI) 05/14/2014 Dense vegetation limits the inspector's visibility to identify signs of pipe failure (leaks) along the slope. Recommend removing vegetation along pipe alignment to conduct proper inspection of structure. Sediment buildup in pipe visible on landward side--recommend clearing. (O. Magana - DWR UCIP) FIELD_STRUCT_DESC: 24-inch corrugated metal gravity drainage pipe (CMP) through the levee, 8.0 feet below the crown. Flap gate on the waterside (WS) end. Brass cap No. 115 bench mark (BM) on the headwall on the landside (LS). [Additional Reference(s): DWR Levee Log, 2002, (HLM 10.82). USACE San Joaquin O&M Manual, Unit No. 601, Part No. 1, 1967, Amended in 1978, Revised 20 June 1985, (HLM 10.81)]. FS Date: 6/7/2021

LS view: Closeup of pipe inlet and slidegate at toe.

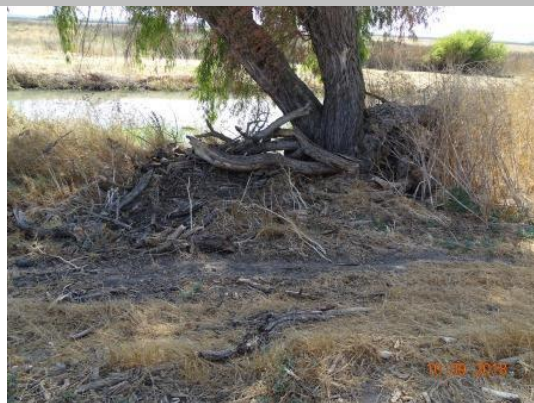
Photo 1 of 1 : SP_2022_NA0010_120_14_20220308_00002.jpg

LM Start	10.94	Rating **	M	Issue No.	14
LM End	10.94	Issue Type +	Ma	Location *	LS
Category	Earthen Levee			GPS Latitude/Longitude	
				Start	End
Item	Encroachments			37.205711 °	37.205711 °
				-120.774741 °	-120.774741 °
DWR ID	DWR_NA0010_02B_f_2015_14				
Comment Code					
PR : Prunings					
Inspector Comment					
Remove prunings from landside toe.

Prunings at landside toe. (Fall 2018)

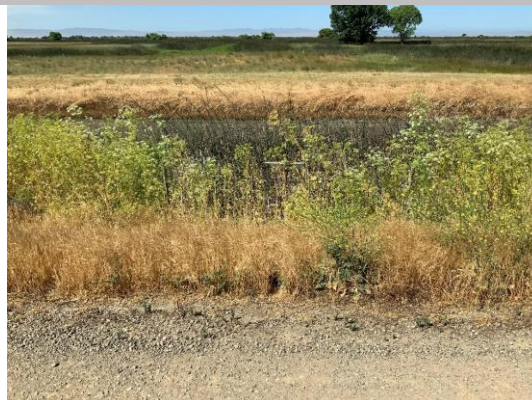
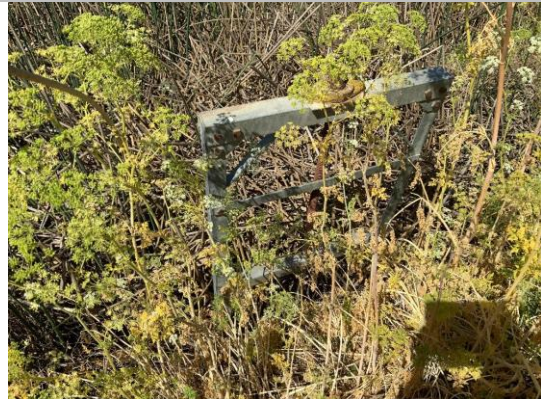
Comment Code					
Inspector Comment					
FS_ID:70961 DS_ID:19689 EP_NO: N/A Repair Type: Non-Urgent Crossing Status: Found UCIP Comments: 06/7/2021 The record remains Non-Urgent. Dense vegetation covering LS pipe inlet limiting inspection, recommend removal. No permit was found authorizing this encroachment. CVFPB will need to review crossing to determine owner. The UCIP inspection was completed with GEI staff, P. Espinoza. (H. Dunn- GEI) 05/14/201 Dense vegetation limits the inspector's visibility to identify signs of pipe failure (leaks) along the slope. Recommend removing vegetation along pipe alignment to conduct proper inspection of structure. (O. Magana - DWR UCIP) FIELD_STRUCT_DESC: 24-inch corrugated metal gravity drainage pipe (CMP) through the levee, 8.0 feet below the crown. Flap gate on the waterside (WS) end. Brass cap No. 115 bench mark (BM) on the headwall on the landside (LS). [Additional Reference(s): DWR Levee Log, 2002, (HLM 11.18). USACE San Joaquin O&M Manual, Unit No. 601, Part No. 1, 1967, Amended in 1978, Revised 20 June 1985, (HLM 11.17)]. FS Date: 6/7/2021

LS view: Headwall barely visible at toe, inlet covered in vegetation.
