**Flood Control Project Maintenance
Levee Inspections
LMA District Cover Sheet**

Lower San Joaquin Levee District

**Flood Control Project Maintenance
Levee Inspections
Unit Cover Sheet**

Levee Inspection Report By Mile - Spring 2022

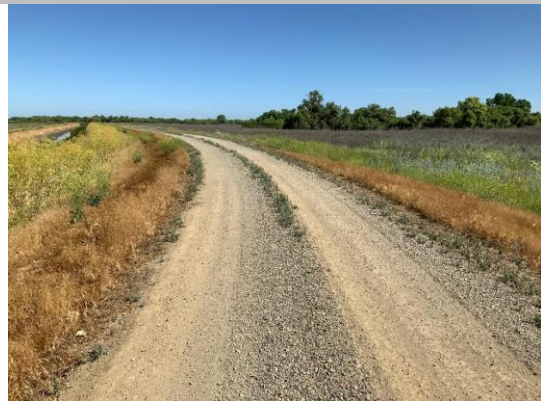
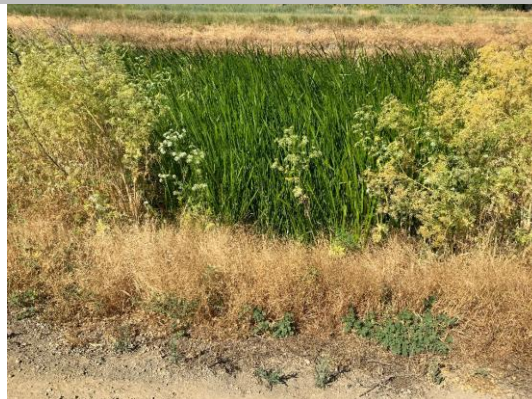
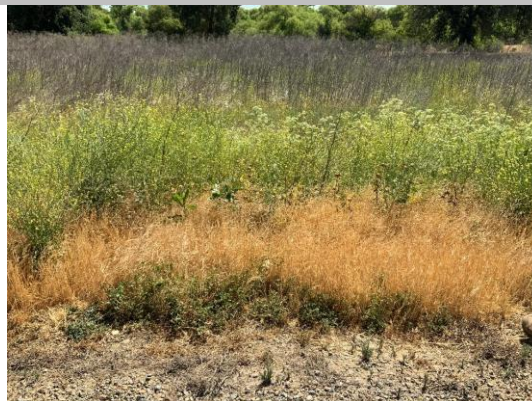
UCIP Comments: 06/7/2021 The record remains Non-Urgent. Dense vegetation over LS end, cannot see pipe inlet, recommend vegetation removal. WS flapgate has some vegetation covering it, recommend clearing. No permit was found authorizing this encroachment. CVFPB will need to review crossing to determine owner. The UCIP inspection was completed with GEI staff, P. Espinoza. (H. Dunn ? GEI)

05/14/2014 Dense vegetation limits the inspector's visibility to identify signs of pipe failure (leaks) along the slope. Recommend removing vegetation along pipe alignment to conduct proper inspection of structure. (O. Magana - DWR UCIP)

LS view: Toe from crown, dense vegetation, no pipe visible.

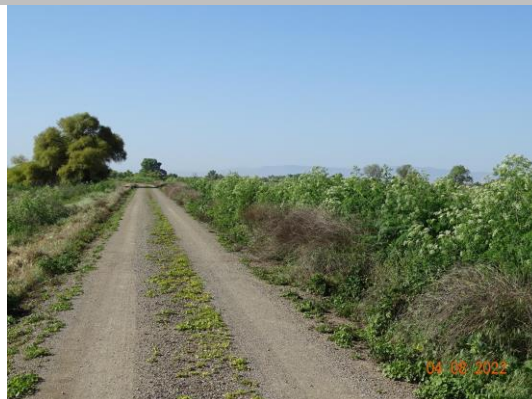
Photo 1 of 1 : SP_2022_NA0010_120_20_20220412_00053.jpg

LM Start	11.43	Rating **	U	Issue No.	20
LM End	11.67	Issue Type +	Ma	Location *	LS
Category	Earthen Levee			GPS Latitude/Longitude	
				Start	End
Item	Vegetation			37.201272 °	37.198031 °
				-120.768446 °	-120.768223 °
DWR ID	DWR_NA0010_02B_s_2022_20				
Comment Code					
V1 : Control annual grass and weeds on the levee slopes and easements.					
Inspector Comment

View of vegetation growing on the landside slope. (Spring 2022)

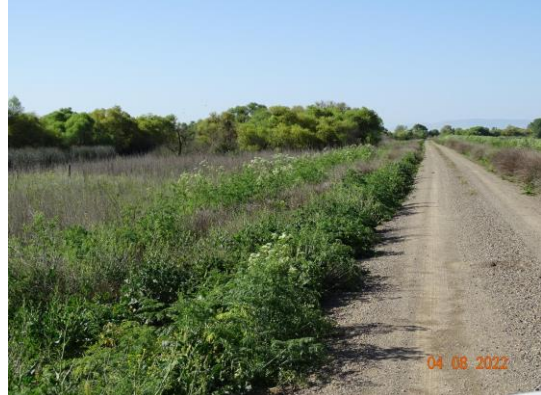
Photo 1 of 1 : SP_2022_NA0010_120_23_20220412_00054.jpg

LM Start	12.09	Rating **	U	Issue No.	23
LM End	12.17	Issue Type +	Ma	Location *	WS
Category	Earthen Levee			GPS Latitude/Longitude	
				Start	End
Item	Vegetation			37.193218 °	37.191982 °
				-120.763943 °	-120.764382 °
DWR ID	DWR_NA0010_02B_s _ 2022_23				
Comment Code					
V1 : Control annual grass and weeds on the levee slopes and easements.					
Inspector Comment

Looking upstream along the waterside slope at dense vegetation.
(Spring 2022)

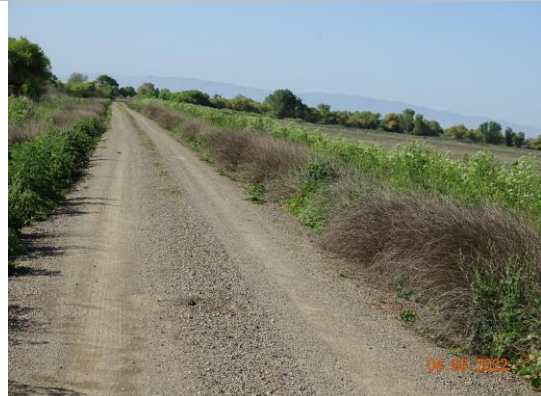
Photo 1 of 1 : SP_2022_NA0010_120_21_20220412_00055.jpg

LM Start	12.09	Rating **	U	Issue No.	21
LM End	13.75	Issue Type +	Ma	Location *	LS
Category	Earthen Levee			GPS Latitude/Longitude	
				Start	End
Item	Vegetation			37.193218 °	37.172226 °
				-120.763943 °	-120.761194 °
DWR ID	DWR_NA0010_02B_s _ 2022_21				
Comment Code					
V1 : Control annual grass and weeds on the levee slopes and easements.					
Inspector Comment

View of heavy vegetation on the landside slope. (Spring 2022)

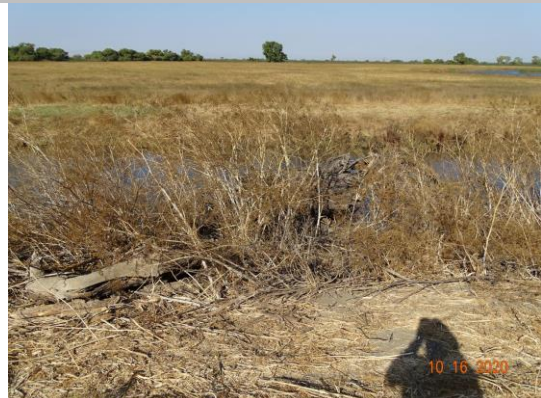
Photo 1 of 1 : SP_2022_NA0010_120_1_20220308_00001.jpg

LM Start	12.21	Rating **	M	Issue No.	1
LM End	12.21	Issue Type +	Ma	Location *	LS
Category	Earthen Levee			GPS Latitude/Longitude	
				Start	End
Item	Encroachments			37.191528 °	37.191528 °
				-120.764541 °	-120.764541 °
DWR ID	DWR_NA0010_02B_f _ 2014_1				
Comment Code					
TR : Tree or limb					
Inspector Comment					
Fallen tree limbs are located on the landside slope.

Fallen tree on the landside slope. (Fall 2020)

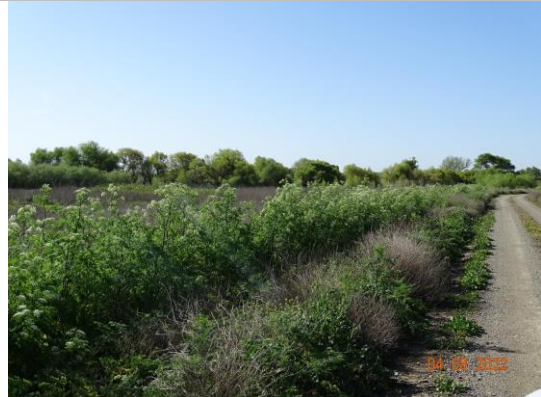
Photo 1 of 1 : SP_2022_NA0010_120_24_20220412_00056.jpg

LM Start	12.46	Rating **	U	Issue No.	24
LM End	13.75	Issue Type +	Ma	Location *	WS
Category	Earthen Levee			GPS Latitude/Longitude	
				Start	End
Item	Vegetation			37.188132 °	37.172226 °
				-120.766132 °	-120.761194 °
DWR ID	DWR_NA0010_02B_s_2022_24				
Comment Code					
V1 : Control annual grass and weeds on the levee slopes and easements.					
Inspector Comment

View of the waterside slope looking upstream. (Spring 2022)

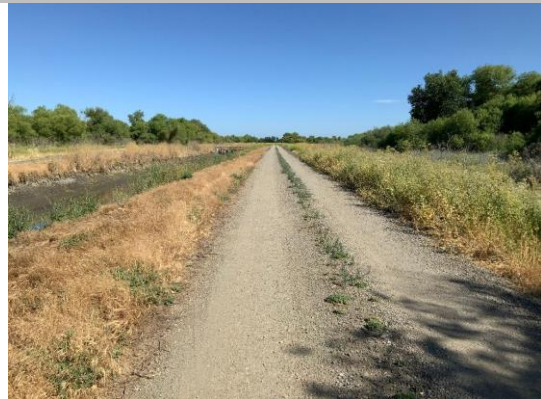
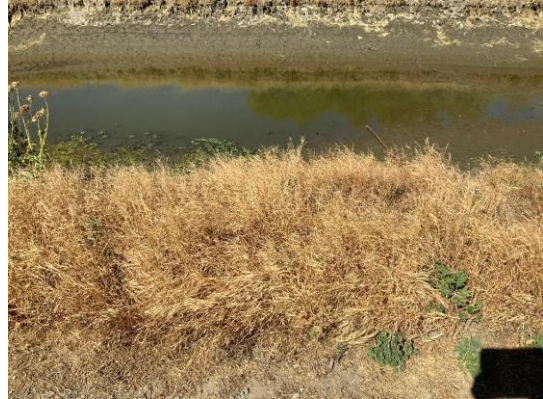
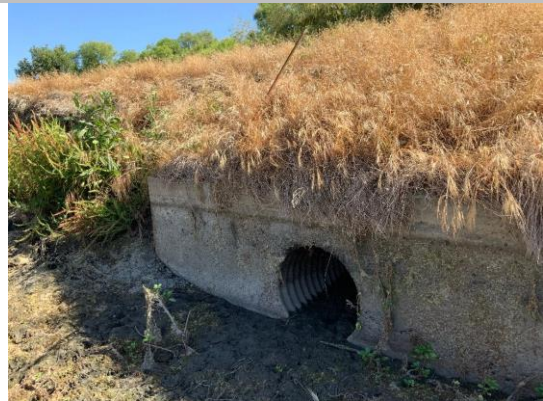
FS_ID:70963
DS_ID:19663
EP_NO: N/A
Repair Type: Non-Urgent
Crossing Status: Found
UCIP Comments: 06/7/2021 The record remains Non-Urgent. Sediment buildup inside LS pipe inlet, recommend cleaning out. Dense vegetation over WS end limited inspection, recommend removal. No permit was found authorizing this encroachment. CVFPB will need to review crossing to determine owner. The UCIP inspection was completed with GEI staff, P. Espinoza. (H. Dunn - GEI) 05/14/201 Dense vegetation limits the inspector's visibility to identify signs of pipe failure (leaks) along the slope. Recommend removing vegetation along pipe alignment to conduct proper inspection of structure. Sediment buildup in pipe-- recommend clearing. (O. Magana - DWR UCIP)
FIELD_STRUCT_DESC: 24-inch corrugated metal gravity drainage pipe (CMP) through the levee, 6.5 feet below the crown. Slide gate in a pipe riser unit on the waterside (WS) slope. [Additional Reference(s): DWR Levee Log, 2002, (HLM 13.23). USACE San Joaquin O&M Manual, Unit No. 601, Part No. 1, 1967, Amended in 1978, Revised 20 June 1985, (HLM 13.22)].

LS view: Slope, headwall, and pipe inlet at toe.

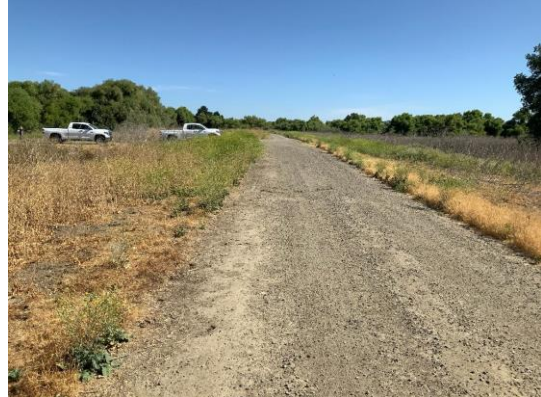
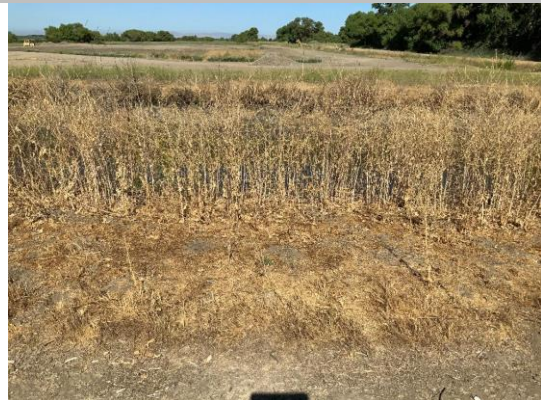
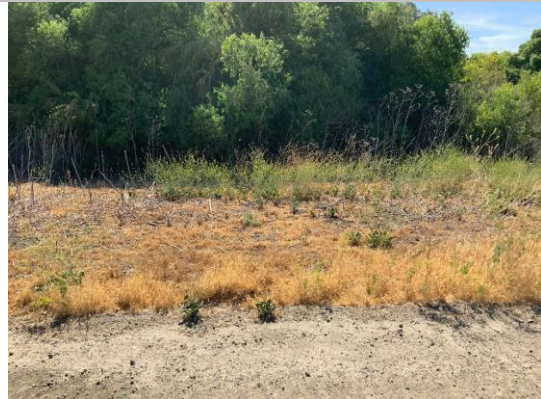
Comment Code					
Inspector Comment					
FS_ID:70964 DS_ID:19664 EP_NO: 14138 Repair Type: Non-Urgent Crossing Status: Not Found UCIP Comments: 06/7/2021 The record remains Non-Urgent. Pipe not found by visual inspection. Dense vegetation on either side, no pipe visible. Recommend removing vegetation to assess if pipe is there. The UCIP inspection was completed with GEI staff, P. Espinoza. (H. Dunn - GEI)05/14/201 Dense vegetation limits the inspector's visibility to identify signs of pipe failure (leaks) along the slope. Recommend removing vegetation along pipe alignment to conduct proper inspection of structure. (O. Magana - DWR UCIP) FIELD_STRUCT_DESC: 24-inch corrugated metal gravity drainage pipe (CMP) through the levee, 10.0 feet below the crown. Concrete cutoff wall at the center of the levee. Flap gate on the landside (LS) end. Screw gate on the waterside (WS) end with accessible walkway. (24-inch reinforced concrete [RC] pipe authorized under Permit No. 14138, 1985 - United States Fish and Wildlife Service). [Additional Reference(s): DWR Levee Log, 2002, (HLM 13.71)]. FS Date: 6/7/2021

LS view: Toe from crown, pipe not visible.

WS view: Toe from crown, pipe not visible.

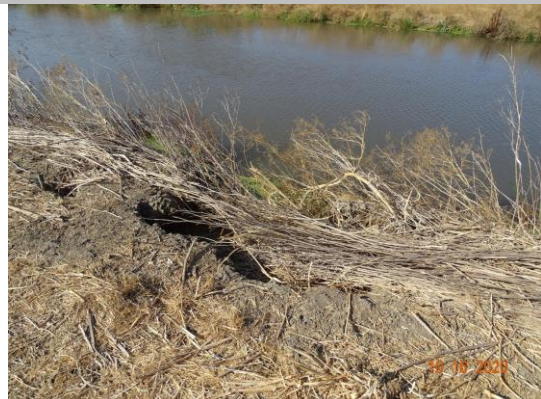
Photo 1 of 1 : SP_2022_NA0010_120_25_20220308_00011.jpg

LM Start	13.72	Rating **	M	Issue No.	25
LM End	13.72	Issue Type +	Ma	Location *	LS
Category	Earthen Levee			GPS Latitude/Longitude	
				Start	End
Item	Erosion / Bank Caving			37.172648 °	37.172648 °
				-120.761157 °	-120.761157 °
DWR ID	DWR_NA0010_02B_f_2018_25				
Comment Code					
E1 : Note and monitor erosion site.					
Inspector Comment					
Erosion is occurring into the landside bank.

View of erosion pocket in the landside slope. (Fall 2020)

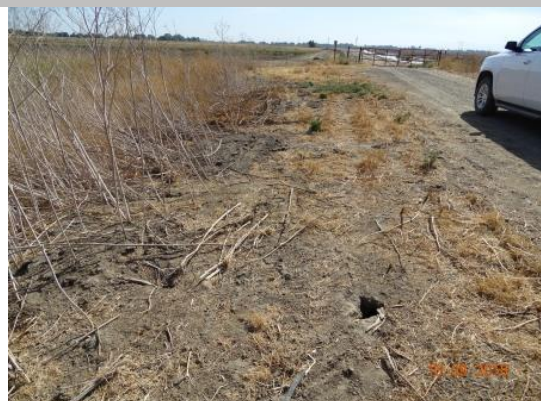
Photo 1 of 1 : SP_2022_NA0010_120_22_20220308_00008.jpg

LM Start	13.73	Rating **	M	Issue No.	22
LM End	13.73	Issue Type +	Ma	Location *	WS
Category	Earthen Levee			GPS Latitude/Longitude	
				Start	End
Item	Animal Control			37.172387 °	37.172387 °
				-120.761190 °	-120.761190 °
DWR ID	DWR_NA0010_02B_f_2018_22				
Comment Code					
A1 : Exterminate rodents and backfill and compact or grout burrows.					
Inspector Comment					
There are several rodent burrows observed at this location.

View of waterside slope looking upstream. (Fall 2018)

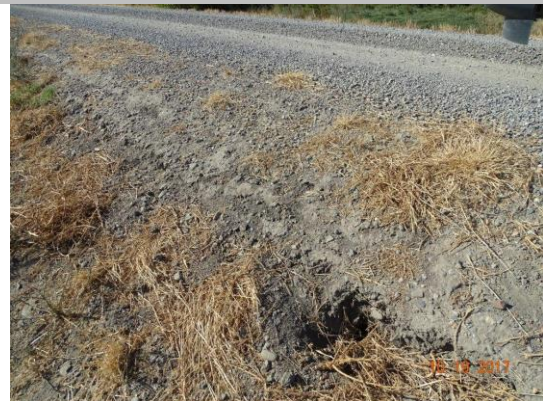
Photo 1 of 1 : SP_2022_NA0010_121_67_20220308_00008.jpg

LM Start	0.19	Rating **	M	Issue No.	67
LM End	0.19	Issue Type +	Ma	Location *	LS
Category	Earthen Levee			GPS Latitude/Longitude	
				Start	End
Item	Animal Control			37.109013 °	37.109013 °
				-120.587799 °	-120.587799 °
DWR ID	DWR_NA0010_03_s_2015_67				
Comment Code					
A3 : No rodents visible, but rodent burrows visible; need to backfill and compact or grout burrows.					
Inspector Comment					
Rodent holes are noted on the landside slope.

Looking southwest at the landside shoulder.

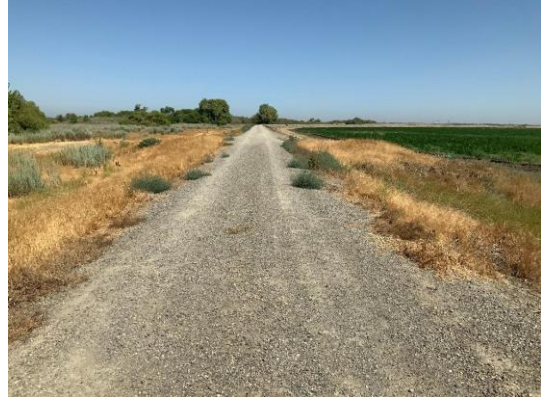
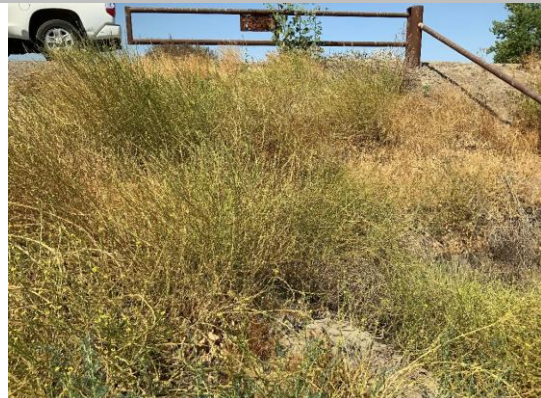
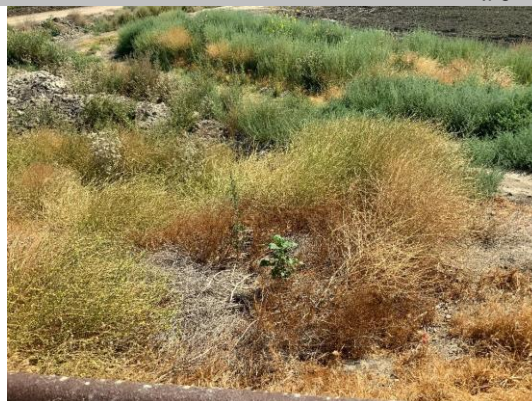
Comment Code					
Inspector Comment					
FS_ID:70965 DS_ID:19691 EP_NO: N/A Repair Type: Non-Urgent Crossing Status: Found UCIP Comments: 07/12/2021 The record remains Non-Urgent. Dense vegetation over LS pipe inlet, headwall just barely visible, recommend removal. No permit was found authorizing this encroachment. CVFPB will need to review crossing to determine owner. The UCIP inspection was completed with GEI staff, P. Espinoza. (H. Dunn ? GEI) 04/17/2014 Need to contact owner. Recommend removing tall grass on landward slope and clearing sediment build up inside pipe. (O. Magana - DWR UCIP) FIELD_STRUCT_DESC: 24-inch corrugated metal gravity drainage pipe (CMP) through the levee, 11.3 feet below the crown. Flap gate on the waterside (WS) end. [Additional Reference(s): DWR Levee Log, 2002, (HLM 0.43). USACE San Joaquin O&M Manual, Unit No. 601, Part No. 1, 1967, Amended in 1978, Revised 20 June 1985, (HLM 0.43). DWR As-Built Specification No. 62-03, Sheet No. 10, 18 June 1962, (HLM 0.43)]. FS Date: 7/12/2021

Levee crown looking upstream.

LS view: Slope from toe.

LS view: Toe from crown.

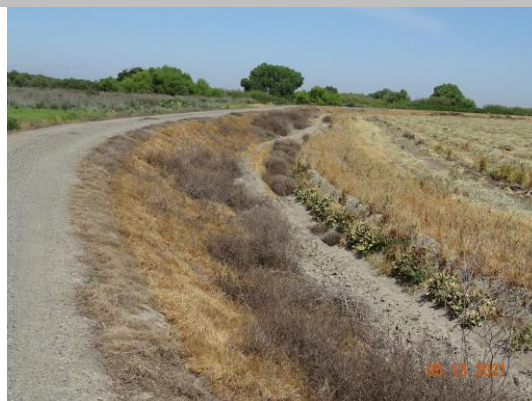
Photo 1 of 1 : SP_2022_NA0010_121_13_20220308_00006.jpg

LM Start	0.43	Rating **	M	Issue No.	13
LM End	2.02	Issue Type +	En	Location *	LS
Category	Earthen Levee			GPS Latitude/Longitude	
				Start	End
Item	Encroachments			37.106072 °	37.089499 °
				-120.585636 °	-120.568041 °
DWR ID	DWR_NA0010_03_s_2021_13				
Comment Code					
DT : Ditch					
Inspector Comment					
Landowner has dug a ditch in the landside toe.

View of ditch dug on the landside toe. (Spring 2021)

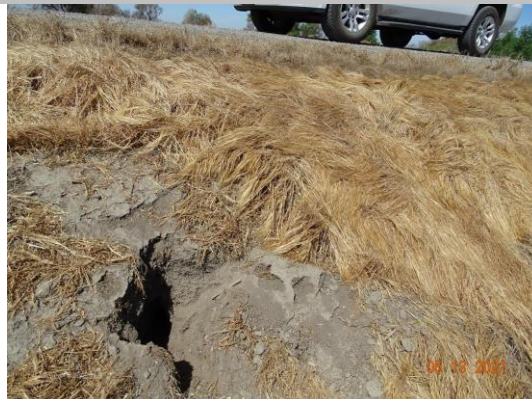
Photo 1 of 1 : SP_2022_NA0010_121_10_20220308_00005.jpg

LM Start	0.57	Rating **	U	Issue No.	10
LM End	0.57	Issue Type +	Ma	Location *	LS
Category	Earthen Levee			GPS Latitude/Longitude	
				Start	End
Item	Animal Control			37.104343 °	37.104343 °
				-120.584348 °	-120.584348 °
DWR ID	DWR_NA0010_03_s_2021_10				
Comment Code					
A3 : No rodents visible, but rodent burrows visible; need to backfill and compact or grout burrows.					
Inspector Comment

Several large rodent burrows observed at this location. (Spring 2021)

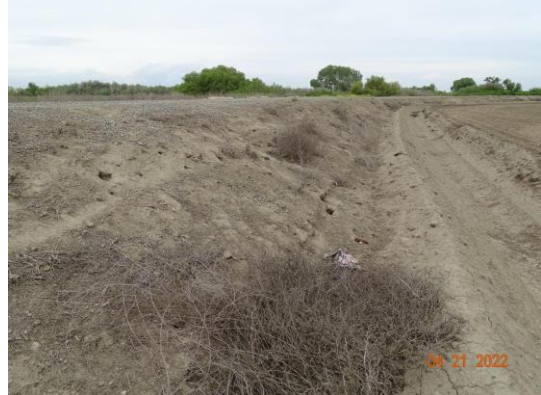
Photo 1 of 1 : SP_2022_NA0010_121_12_20220425_00022.jpg

LM Start	1.70	Rating **	M	Issue No.	12
LM End	1.78	Issue Type +	Ma	Location *	LS
Category	Earthen Levee			GPS Latitude/Longitude	
				Start	End
Item	Animal Control			37.092231 °	37.091302 °
				-120.572337 °	-120.571632 °
DWR ID	DWR_NA0010_03_f _ 2020_12				
Comment Code					
A1 : Exterminate rodents and backfill and compact or grout burrows.					
Inspector Comment

View of several animal holes in the landside slope. (Spring 2022)

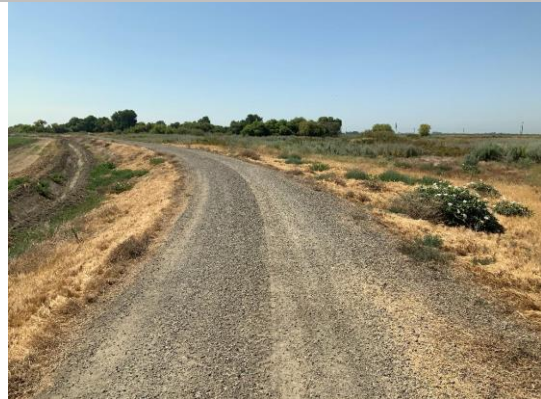
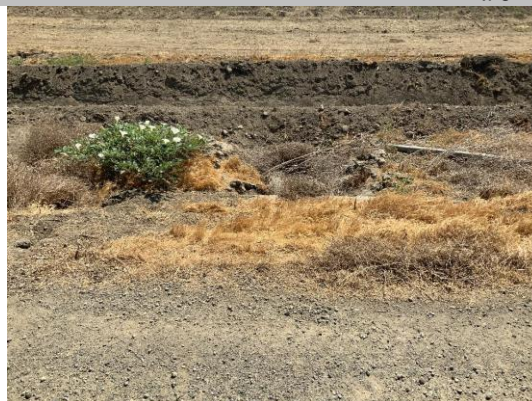
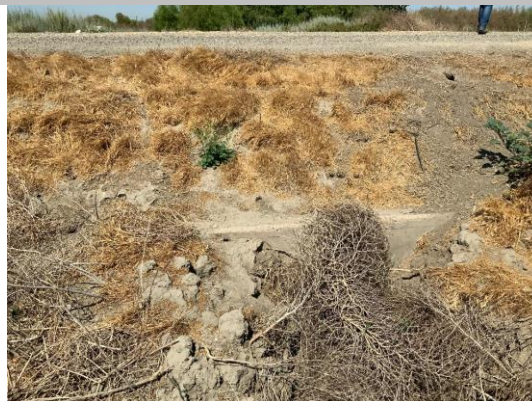
Comment Code					
Inspector Comment					
FS_ID:70967 DS_ID:19693 EP_NO: N/A Repair Type: Non-Urgent Crossing Status: Found UCIP Comments: 07/12/2021 The record remains Non-Urgent. There is dense vegetation over LS pipe inlet and WS flapgate, recommend removal. No permit was found authorizing this encroachment. CVFPB will need to review crossing to determine owner. The UCIP inspection was completed with GEI staff, P. Espinoza. (H. Dunn ? GEI) 04/17/2014 Sediment buildup in pipe visible from landward side-- recommend clearing. (O. Magana - DWR UCIP) FIELD_STRUCT_DESC: 24-inch corrugated metal gravity drainage pipe (CMP) through the levee, 6.8 feet below the crown. Flap gate on the waterside (WS) end. [Additional Reference(s): DWR Levee Log, 2002, (HLM 1.73). USACE San Joaquin O&M Manual, Unit No. 601, Part No. 1, 1967, Amended in 1978, Revised 20 June 1985, (HLM 1.72). DWR As-Built Specification No. 62-03, Sheet No. 11, 18 June 1962, (HLM 1.72)]. FS Date: 7/12/2021

Levee crown.

LS view: Toe from crown.

LS view: Slope and headwall from toe.

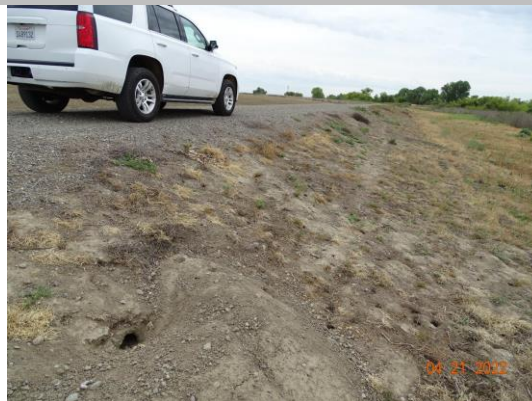
Photo 1 of 1 : SP_2022_NA0010_121_17_20220425_00023.jpg

LM Start	1.77	Rating **	M	Issue No.	17
LM End	1.77	Issue Type +	Ma	Location *	WS
Category	Earthen Levee			GPS Latitude/Longitude	
				Start	End
Item	Animal Control			37.091446 °	37.091446 °
				-120.571777 °	-120.571777 °
DWR ID	DWR_NA0010_03_s_2022_17				
Comment Code					
A1 : Exterminate rodents and backfill and compact or grout burrows.					
Inspector Comment

Multiple rodent burrows observed on the waterside slope. (Spring 2022)

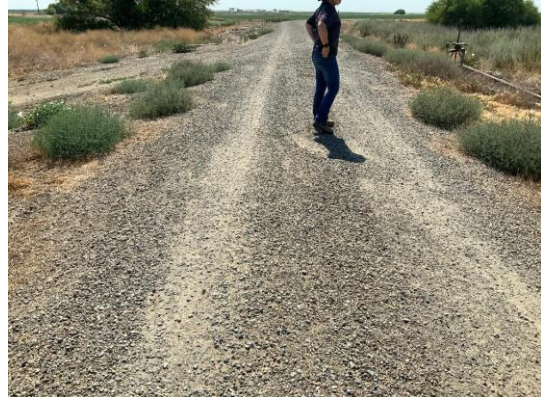
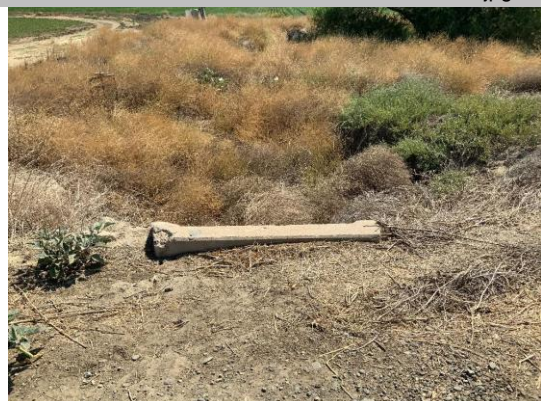
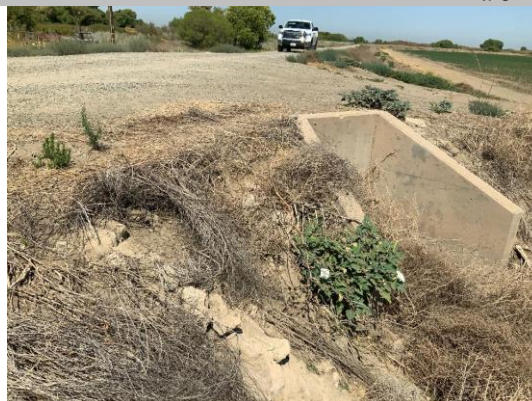
Comment Code					
Inspector Comment					
FS_ID:70968 DS_ID:19694 EP_NO: N/A Repair Type: Non-Urgent Crossing Status: Found UCIP Comments: 07/12/2021 The record remains Non-Urgent. Dense vegetation over WS and LS inlet/outlet, recommend removal. As mentioned in the previous inspection, there is a 16 inch metal pipe directly opposite the WS pipe slidegate/outlet that goes just underground and out through to the channel. Recommend contacting owner for more information on these WS appurtenances. No permit was found authorizing this encroachment. CVFPB will need to review crossing to determine owner. The UCIP inspection was completed with GEI staff, P. Espinoza. (H. Dunn ? GEI) 04/17/2014 Need to contact owner--additional appurtenances found on waterward side not part of original description. Unable to determine if walkway, pump, and pipe through waterward berm is if part of original crossing. (O. Magana - DWR UCIP) FIELD_STRUCT_DESC: 36-inch corrugated metal irrigation discharge pipe (CMP) through the levee, 6.6 feet below the crown. Pump on the riverbank. Slide gate on the waterside (WS) end. [Additional Reference(s): DWR Levee Log, 2002, (HLM 2.05). USACE San Joaquin O&M Manual, Unit No. 601, Part No. 1, 1967, Amended in 1978, Revised 20 June 1985, (HLM 2.05). DWR As-Built Specification No. 62-03, Sheet No. 11, 18 June 1962, (HLM 2.05)]. FS Date: 7/12/2021

Levee crown.

LS view: Headwall visible at toe from crown.

LS view: Slope from toe.

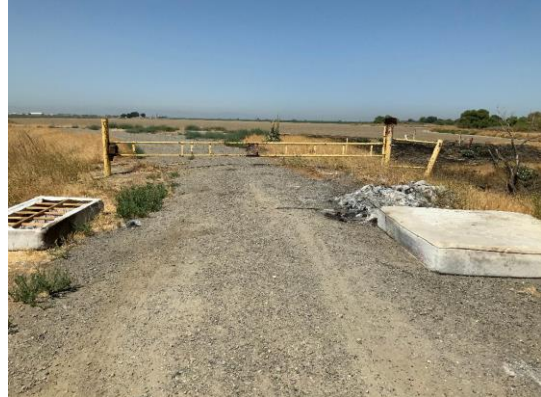
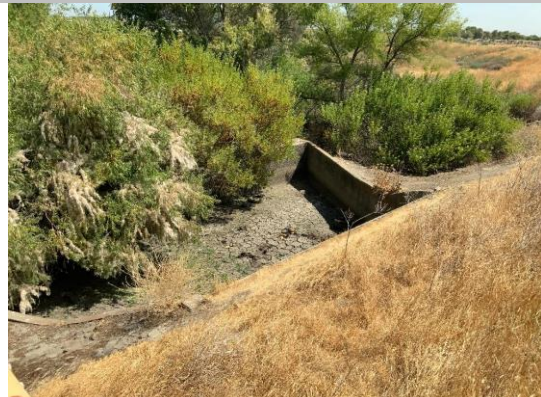
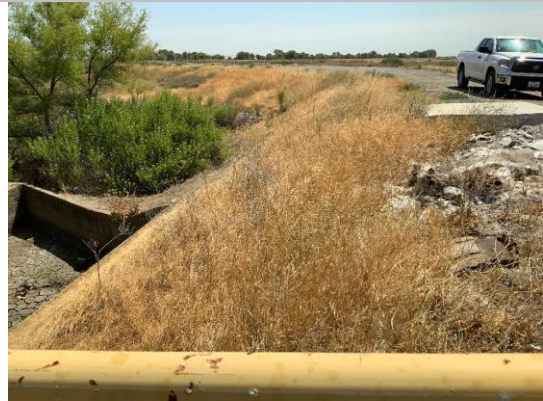
Comment Code						
Inspector Comment						
FS_ID:70969 DS_ID:19977 EP_NO: 5024 Repair Type: Non-Urgent Crossing Status: Found UCIP Comments: 07/12/2021 The record remains Non-Urgent. WS pipe outlet is underwater, limited inspection. LS headwall and pipe inlets have human trash around and safety concerns to inspectors due to homeless encampments. Limited inspection on both WS due to water and LS due to safety concerns to the inspectors. The UCIP inspection was completed with GEI staff, P. Espinoza. (H. Dunn ? GEI) 10/27/2017 This structure is inspected annually under the Structure and Channel Summer Inspection (part of the Levee Inspection Program) conducted by the DWR Flood Project Integrity and Inspection Branch (FPIIB). (O. Magana - DWR UCIP) 04/17/2014 Slide gates blocked by sediment. Recommend contacting owner to determine status of crossing. Crossing appears to be abandoned. (O. Magana - DWR UCIP) FIELD_STRUCT_DESC: [San Joaquin River Diversion Structure] 1 of 4: 72-inch by 60-inch reinforced concrete box gravity drainage culvert (RCBC) through the levee, 21.0 feet below the crown. Slide gate on the waterside (WS). Concrete headwall on each end. Landside (LS) slope cobble revetted. Flashboards on the downstream side of the structure. [Additional Reference(s): DWR Levee Log, 2002, (HLM 0.03). DWR As-Built Specification No. 62-03, Sheet No. 10, 18 June 1962]. FS Date: 7/12/2021

Levee crown.

LS view: Toe from crown.

LS view: Slope from crown.

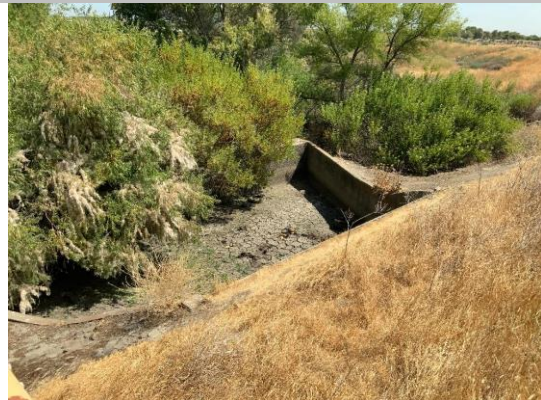
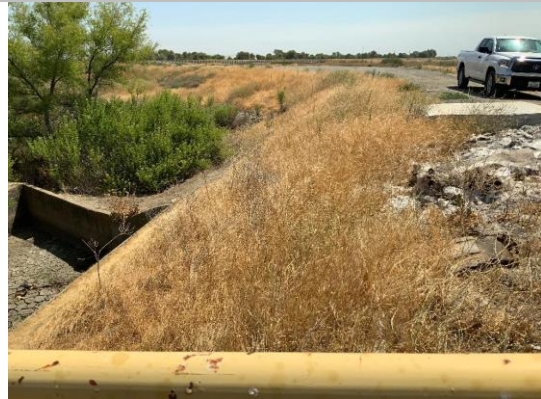
Comment Code						
Inspector Comment						
FS_ID:70970 DS_ID:24856 EP_NO: 5024 Repair Type: Non-Urgent Crossing Status: Found UCIP Comments: 07/12/2021 The record remains Non-Urgent. WS pipe outlet is underwater, limited inspection. LS headwall and pipe inlets have human trash around and safety concerns to inspectors due to homeless encampments. Limited inspection on both WS due to water and LS due to safety concerns to the inspectors. The UCIP inspection was completed with GEI staff, P. Espinoza. (H. Dunn ? GEI) 10/27/2017 This structure is inspected annually under the Structure and Channel Summer Inspection (part of the Levee Inspection Program) conducted by the DWR Flood Project Integrity and Inspection Branch (FPIIB). (O. Magana - DWR UCIP) 04/17/2014 Slide gates blocked by sediment. Recommend contacting owner to determine status of crossing. Crossing appears to be abandoned. (O. Magana - DWR UCIP) FIELD_STRUCT_DESC: [San Joaquin River Diversion Structure] 2 of 4: 72-inch by 60-inch reinforced concrete box gravity drainage culvert (RCBC) through the levee, 21.0 feet below the crown. Slide gate on the waterside (WS). Concrete headwall on each end. Landside (LS) slope cobble revetted. Flashboards on the downstream side of the structure. [Additional Reference(s): DWR Levee Log, 2002, (HLM 0.03). DWR As-Built Specification No. 62-03, Sheet No. 10, 18 June 1962]. FS Date: 7/12/2021

LS view: Headwall visible at toe from crown.

LS view: Slope from crown.

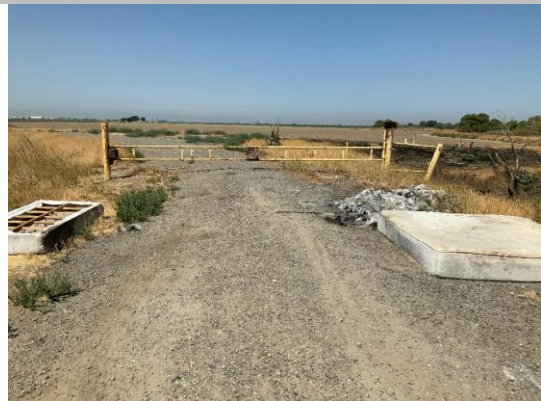
Photo 1 of 3 : UCIP_SP_2022_70971_101391.jpg

FS_ID:70971
DS_ID:24857
EP_NO: 5024
Repair Type: Non-Urgent
Crossing Status: Found
UCIP Comments: 07/12/2021 The record remains Non-Urgent. WS pipe outlet is underwater, limited inspection. LS headwall and pipe inlets have human trash around and safety concerns to inspectors due to homeless encampments. Limited inspection on both WS due to water and LS due to safety concerns to the inspectors. The UCIP inspection was completed with GEI staff, P. Espinoza. (H. Dunn ? GEI)10/27/2017 This structure is inspected annually under the Structure and Channel Summer Inspection (part of the Levee Inspection Program) conducted by the DWR Flood Project Integrity and Inspection Branch (FPIIB). (O. Magana - DWR UCIP) 04/17/2014 Slide gates blocked by sediment. Recommend contacting owner to determine status of crossing. Crossing appears to be abandoned. (O. Magana - DWR UCIP) FIELD_STRUCT_DESC: [San Joaquin River Diversion Structure] 3 of 4: 72-inch by 60-inch reinforced concrete box gravity drainage culvert (RCBC) through the levee, 21.0 feet below the crown. Slide gate on the waterside (WS). Concrete headwall on each end. Landside (LS) slope cobble revetted. Flashboards on the downstream side of the structure. [Additional Reference(s): DWR Levee Log, 2002, (HLM 0.03). DWR As-Built Specification No. 62-03, Sheet No. 10, 18 June 1962]. FS Date: 7/12/2021

Levee crown.

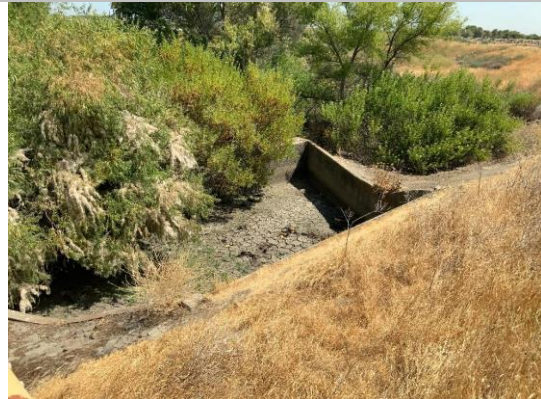
Photo 2 of 3 : UCIP_SP_2022_70971_101389.jpg

LS view: Toe from crown.

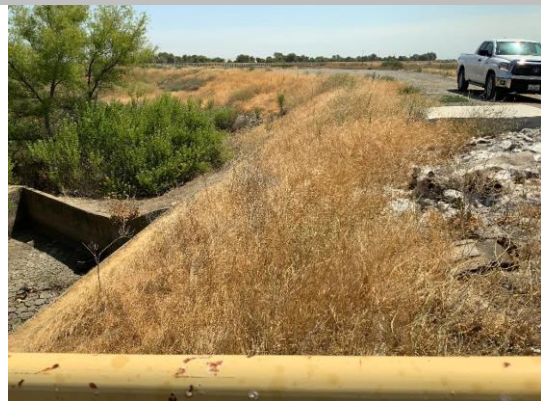
Photo 3 of 3 : UCIP_SP_2022_70971_101390.jpg

LS view: Slope from crown.

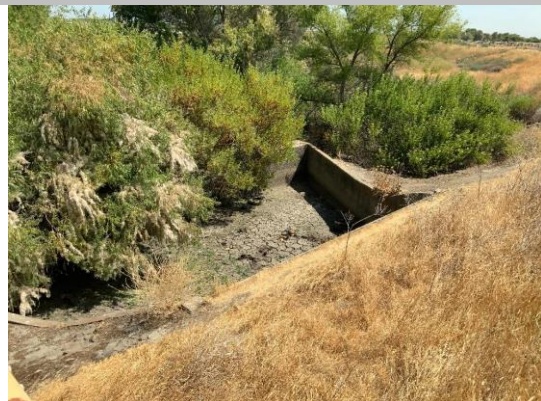
Photo 2 of 3 : UCIP_SP_2022_70972_101395.jpg

Comment Code					
Inspector Comment					
FS_ID:70972 DS_ID:24858 EP_NO: 5024 Repair Type: Non-Urgent Crossing Status: Found UCIP Comments: 07/12/2021 The record remains Non-Urgent. WS pipe outlet is underwater, limited inspection. LS headwall and pipe inlets have human trash around and safety concerns to inspectors due to homeless encampments. Limited inspection on both WS due to water and LS due to safety concerns to the inspectors. The UCIP inspection was completed with GEI staff, P. Espinoza. (H. Dunn ? GEI)10/27/2017 This structure is inspected annually under the Structure and Channel Summer Inspection (part of the Levee Inspection Program) conducted by the DWR Flood Project Integrity and Inspection Branch (FPIIB). (O. Magana - DWR UCIP) 04/17/2014 Slide gates blocked by sediment. Recommend contacting owner to determine status of crossing. Crossing appears to be abandoned. (O. Magana - DWR UCIP) FIELD_STRUCT_DESC: [San Joaquin River Diversion Structure] 4 of 4: 72-inch by 60-inch reinforced concrete box gravity drainage culvert (RCBC) through the levee, 21.0 feet below the crown. Slide gate on the waterside (WS). Concrete headwall on each end. Landside (LS) slope cobble revetted. Flashboards on the downstream side of the structure. [Additional Reference(s): DWR Levee Log, 2002, (HLM 0.03). DWR As-Built Specification No. 62-03, Sheet No. 10, 18 June 1962]. FS Date: 7/12/2021

LS view: Headwall visible at toe from crown.

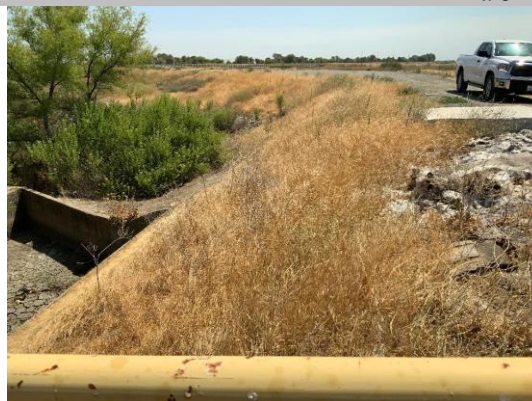
Photo 3 of 3 : UCIP_SP_2022_70972_101396.jpg

LS view: Slope from crown.

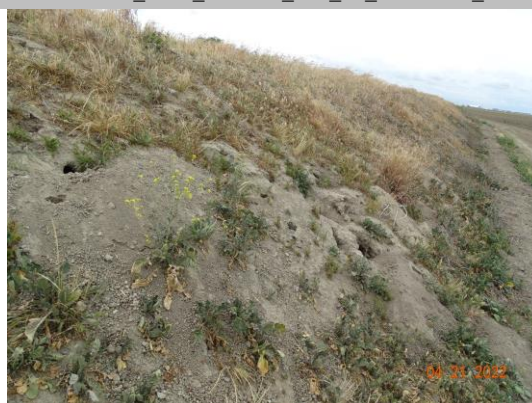
Photo 1 of 1 : SP_2022_NA0010_122_10_20220425_00024.jpg

LM Start	0.10	Rating **	M	Issue No.	10
LM End	0.10	Issue Type +	Ma	Location *	LS
Category	Earthen Levee			GPS Latitude/Longitude	
				Start	End
Item	Animal Control			37.111692 °	37.111692 °
				-120.590312 °	-120.590312 °
DWR ID	DWR_NA0010_04_s_2022_10				
Comment Code					
A1 : Exterminate rodents and backfill and compact or grout burrows.					
Inspector Comment

View of rodent holes on the landside slope. (Spring 2022)

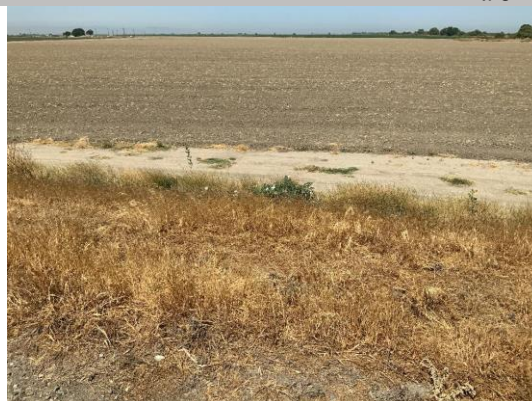
Photo 2 of 3 : UCIP_SP_2022_70973_101402.jpg

LS view: Toe from crown, no pipe visible.

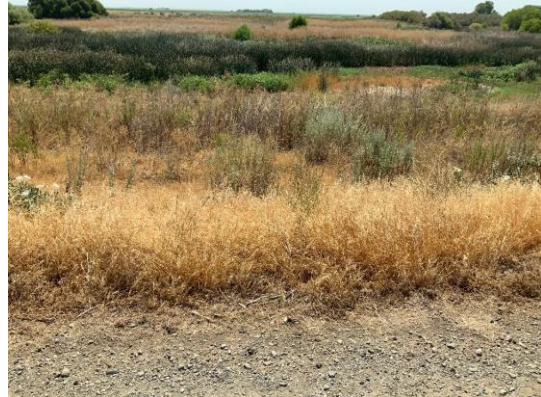
Photo 3 of 3 : UCIP_SP_2022_70973_101401.jpg

WS view: Toe from crown, no pipe visible.

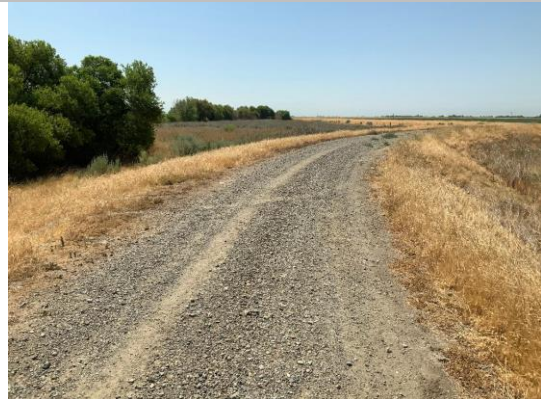
Photo 1 of 3 : UCIP_SP_2022_70974_101404.jpg

FS_ID:70974
DS_ID:19695
EP_NO: N/A
Repair Type: Non-Urgent
Crossing Status: Found
UCIP Comments: 07/12/2021 The record remains Non-Urgent. WS flapgate is underwater and covered by vegetation. LS inlet also covered by vegetation, recommend removal on both ends. No permit was found authorizing this encroachment. CVFPB will need to review crossing to determine owner. The UCIP inspection was completed with GEI staff, P. Espinoza. (H. Dunn ? GEI) 04/17/2014 Sediment and debris blocking concrete headwall located on waterward side. During inspection water was flowing from landward side to waterward side. Recommend removing sediment to confirm condition of flap gate and pipe. (O. Magana - DWR UCIP)
FIELD_STRUCT_DESC: 36-inch corrugated metal gravity drainage pipe (CMP) through the levee, 18.0 feet below the crown. Flap gate on the waterside (WS) end. Concrete headwall on each end. [Additional Reference(s): DWR Levee Log, 2002, (HLM 0.24). USACE San Joaquin O&M Manual, Unit No. 601, Part No. 1, 1967, Amended in 1978, Revised 20 June 1985, (HLM 0.27)].

Levee crown.

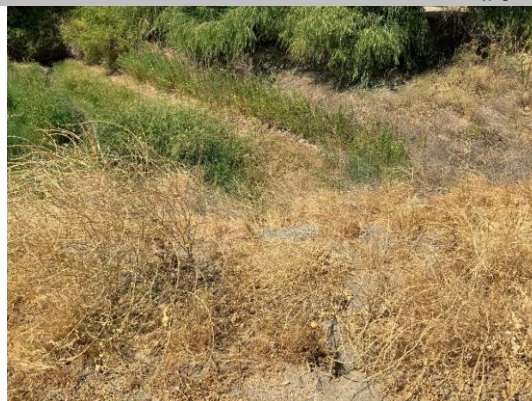
Photo 2 of 3 : UCIP_SP_2022_70974_101405.jpg

LS view: Toe from crown.

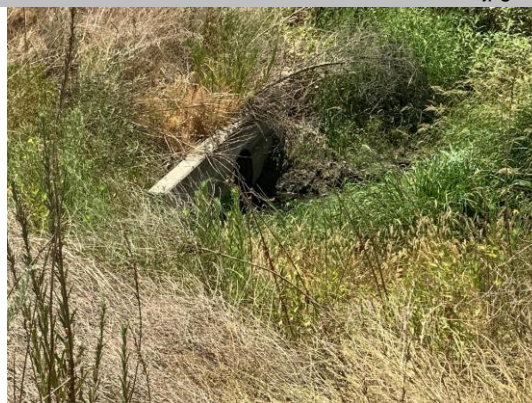
Photo 3 of 3 : UCIP_SP_2022_70974_101406.jpg

LS view: Pipe inlet with water in it at toe.

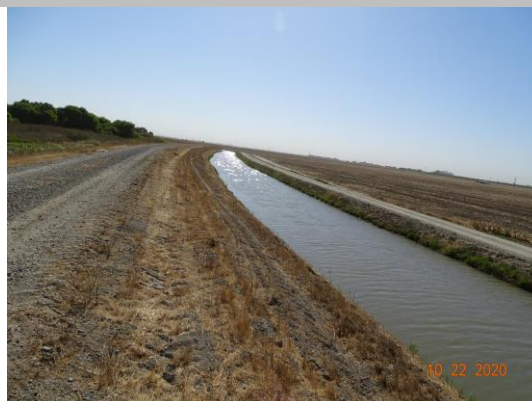
Photo 1 of 1 : SP_2022_NA0010_122_3_20220308_00001.jpg

LM Start	0.32	Rating **	A/W	Issue No.	3
LM End	1.41	Issue Type +	En	Location *	LS
Category	Earthen Levee			GPS Latitude/Longitude	
				Start	End
Item	Encroachments			37.108822 °	37.097556 °
				-120.590718 °	-120.578130 °
DWR ID	DWR_NA0010_04_s_2012_3				
Comment Code					
DT : Ditch					
Inspector Comment					
An irrigation ditch is within 10' easement. Shown on the as-built drawings.

Looking upstream at an irrigation ditch at the landside toe. (Fall 2020)

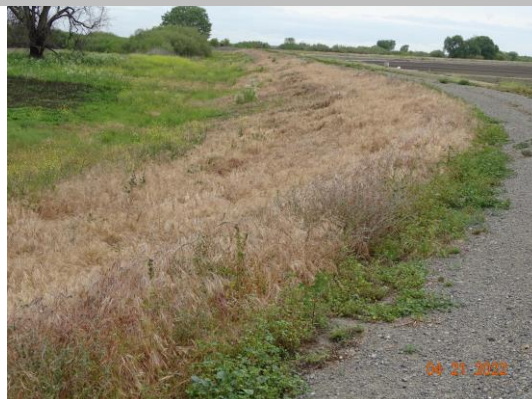
Photo 1 of 1 : SP_2022_NA0010_122_11_20220425_00025.jpg

LM Start	0.36	Rating **	M	Issue No.	11
LM End	1.35	Issue Type +	Ma	Location *	WS
Category	Earthen Levee			GPS Latitude/Longitude	
				Start	End
Item	Vegetation			37.108376 °	37.098382 °
				-120.590413 °	-120.578273 °
DWR ID	DWR_NA0010_04_s_2022_11				
Comment Code					
V1 : Control annual grass and weeds on the levee slopes and easements.					
Inspector Comment

Looking upstream along the waterside slope. (Spring 2022)

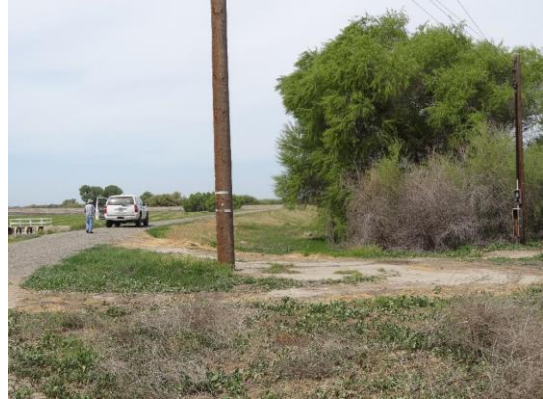
Photo 2 of 3 : UCIP_SP_2022_40530_61988.jpg

Overview of waterward side and levee crown at crossing.

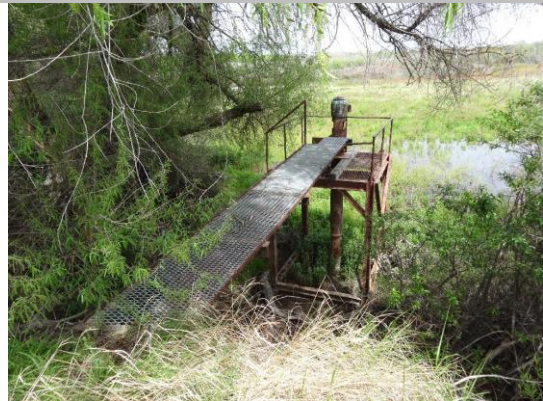
Photo 3 of 3 : UCIP_SP_2022_40530_61986.jpg

Pump and walkway located on waterward side.

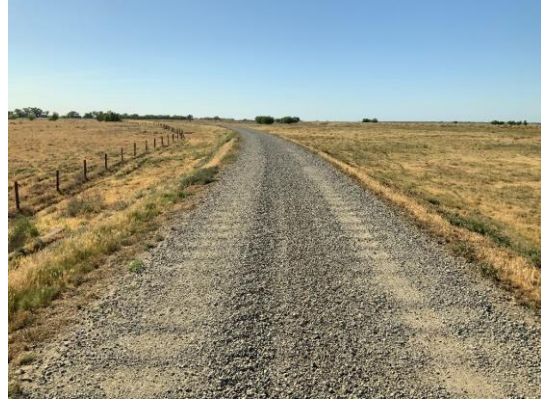
Photo 1 of 3 : UCIP_SP_2022_70983_99634.jpg

Comment Code					
Inspector Comment					
FS_ID:70983 DS_ID:19756 EP_NO: N/A Repair Type: Non-Urgent Crossing Status: Found UCIP Comments: 06/1/2021 Record remains Non-Urgent. DWR DMP internal inspection has not found pipe integrity issues. LOF of crossing is less or equal to 4.0. Recommend next video inspection in 5 years. Some soil sloughing/erosion on the WS slope. No permit was found authorizing this encroachment. CVFPB will need to review crossing to determine owner. The UCIP inspection was completed with GEI staff, P. Espinoza. (H. Dunn ? GEI) 04/09/2014 Debris blocking landward headwall--recommend clearing. (W. Wylie - DWR UCIP) FIELD_STRUCT_DESC: 24-inch corrugated metal gravity drainage pipe (CMP) through the levee, 8.6 feet below the crown. Concrete U-shaped headwall and flap gate on the waterside (WS) end. Concrete headwall on the landside (LS) end. [Additional Reference(s): DWR Levee Log, 2002, (HLM 0.07). USACE San Joaquin O&M Manual, Unit No. 601, Part No. 1, 1967, Amended in 1978, Revised 20 June 1985, (HLM 0.07)]. FS Date: 6/1/2021

levee crown looking downstream.

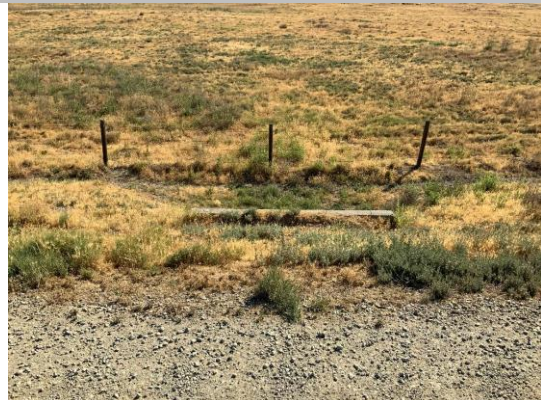
Photo 2 of 3 : UCIP_SP_2022_70983_99635.jpg

LS view: Headwall visible at toe from crown.

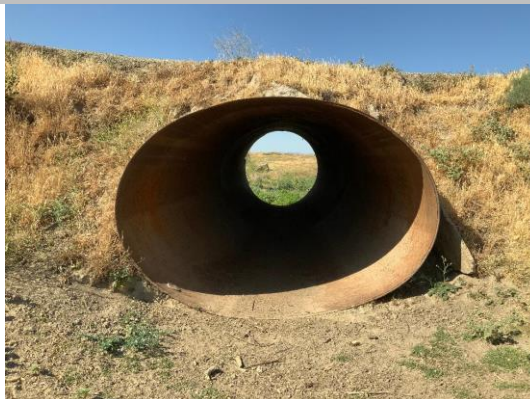
Photo 2 of 3 : UCIP_SP_2022_70984_99642.jpg

LS view: Slope and pipe inlet, top being bent down from toe.

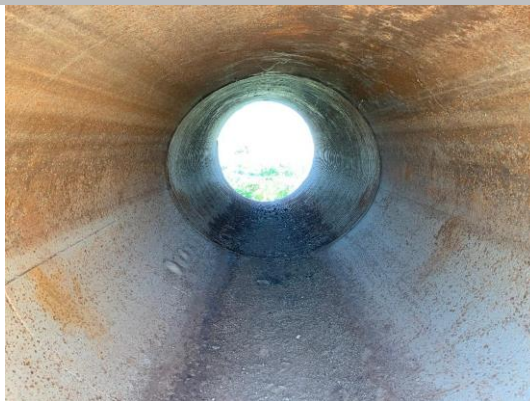
Photo 3 of 3 : UCIP_SP_2022_70984_99643.jpg

LS view: Inside pipe inlet at toe.

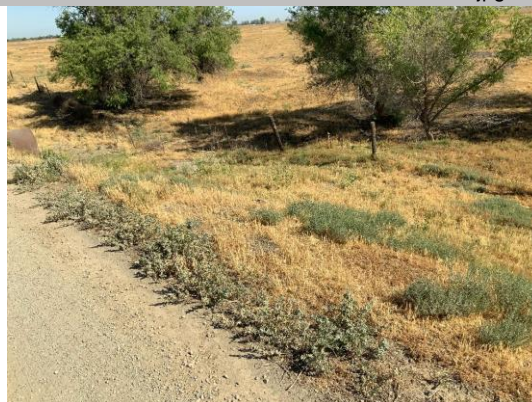
Photo 2 of 3 : UCIP_SP_2022_70985_99648.jpg

LS view: Slope and toe from crown, no pipe visible.

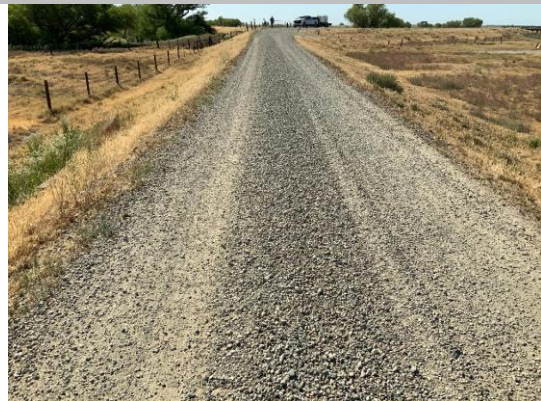
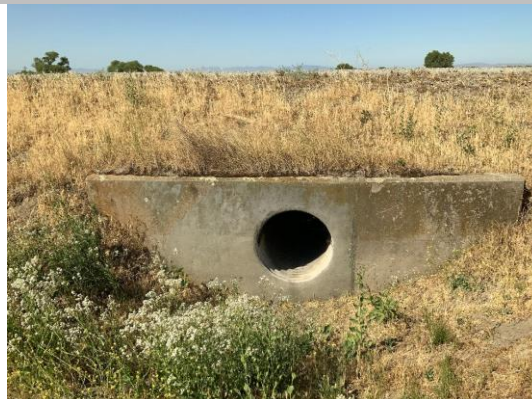
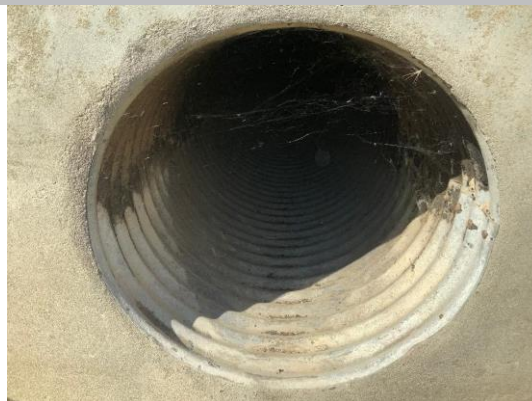
Photo 1 of 3 : UCIP_SP_2022_70986_99654.jpg

FS_ID:70986
DS_ID:19757
EP_NO: N/A
Repair Type: Non-Urgent
Crossing Status: Found
UCIP Comments: 06/1/2021 Record remains Non-Urgent. DWR DMP internal inspection has found pipe integrity issues. LOF of crossing is greater than or equal to 4.1 and less than 5. Crossing will be monitored until funding becomes available for rehabilitation. No permit was found authorizing this encroachment. CVFPB will need to review crossing to determine owner. The UCIP inspection was completed with GEI staff, P. Espinoza. (H. Dunn ? GEI) 04/09/2014 Excess debris on landward headwall--recommend clearing. (W. Wylie - DWR UCIP) FIELD_STRUCT_DESC: 30-inch corrugated metal gravity drainage pipe (CMP) through the levee, 7.5 feet below the crown. Flap gate on the waterside (WS) end. Concrete headwall on the landside (LS) end. Concrete U-shaped headwall on the WS end. [Additional Reference(s): DWR Levee Log, 2002, (HLM 0.58). USACE San Joaquin O&M Manual, Unit No. 601, Part No. 1, 1967, Amended in 1978, Revised 20 June 1985, (HLM 0.59). DWR As-Built Specification No. 63-25, Sheet No. 4, 9 May 1963, (Station -2+15)].

Levee crown looking downstream.

LS view: Slope and headwall from toe.

LS view: Close up of pipe inlet at toe.

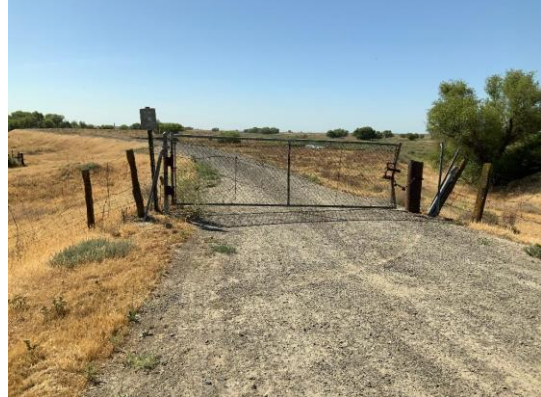
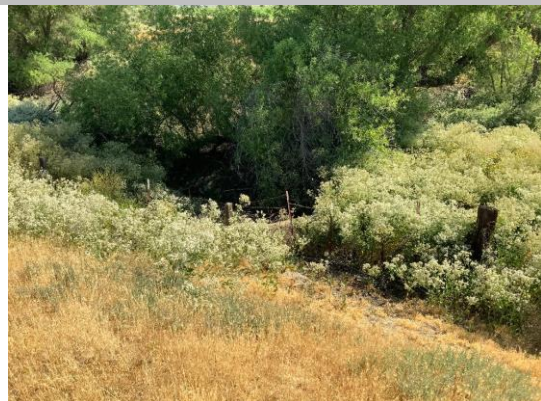
Photo 1 of 3 : UCIP_SP_2022_70987_99659.jpg

FS_ID:70987
DS_ID:19758
EP_NO: N/A
Repair Type: Urgent
Crossing Status: Found
UCIP Comments: 06/1/2021 Record has been upgraded from Non-Urgent to Urgent. DWR DMP internal inspection has found pipe integrity issues. LOF of crossing is greater than or equal to 5 and less than 6. Crossing will be monitored until funding becomes available to address the issues. No closeup inspection of LS pipe end due to dense vegetation and barbed wire. No permit was found authorizing this encroachment. CVFPB will need to review crossing to determine owner. The UCIP inspection was completed with GEI staff, P. Espinoza. (H. Dunn ? GEI)04/09/2014 Dense vegetation limits the inspector's visibility to identify signs of pipe failure (leaks) along the landward slope. Recommend removing vegetation along pipe alignment to conduct proper inspection of structure. (W. Wylie - DWR UCIP)
FIELD_STRUCT_DESC: 36-inch corrugated metal gravity drainage pipe (CMP) through the levee, 13.2 feet below the crown. Flap gate on the waterside (WS) end. Concrete headwall on the landside (LS) end. Concrete U-shaped headwall on the WS end. Cobble revetment around both ends. [Additional Reference(s): DWR Levee Log, 2002, (HLM 0.64). USACE San Joaquin O&M Manual, Unit No. 601, Part No. 1, 1967, Amended in 1978, Revised 20 June 1985, (HLM 0.65). DWR As-Built Specification No. 63-25, Sheet No. 4, 9 May 1963, (HLM 0.65)].

Levee crown looking downstream.

LS view: Headwall barely visible at toe from crown.

WS view: Toe from crown.

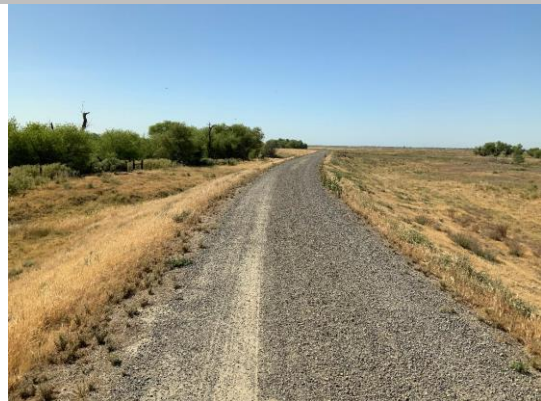
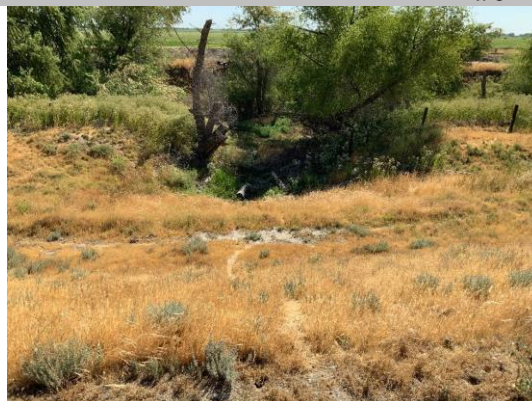
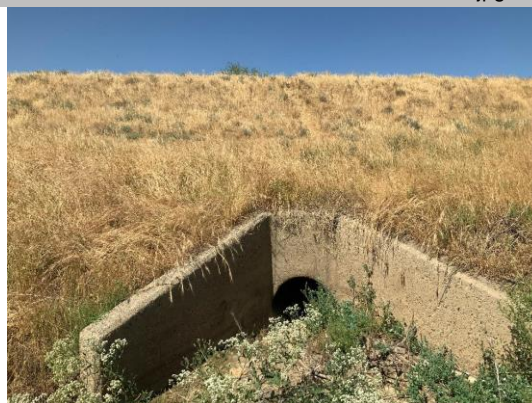
Photo 1 of 3 : UCIP_SP_2022_70988_99664.jpg

FS_ID:70988
 DS_ID:19759
 EP_NO: N/A
 Repair Type: Urgent
 Crossing Status: Found
 UCIP Comments: 06/1/2021 Record has been upgraded from No Action Needed to Urgent. DWR DMP internal inspection has found pipe integrity issues. LOF of crossing is greater than or equal to 5 and less than 6. Crossing will be monitored until funding becomes available to address the issues. No permit was found authorizing this encroachment. CVFPB will need to review crossing to determine owner. The UCIP inspection was completed with GEI staff, P. Espinoza. (H. Dunn ? GEI)
 FIELD_STRUCT_DESC: 24-inch corrugated metal gravity drainage pipe (CMP) through the levee, 14.4 feet below the crown. Flap gate on the waterside (WS) end. Concrete headwall on the landside (LS) end. Concrete U-shaped headwall on the WS end. [Additional Reference(s): DWR Levee Log, 2002, (HLM 0.84). USACE San Joaquin O&M Manual, Unit No. 601, Part No. 1, 1967, Amended in 1978, Revised 20 June 1985, (HLM 0.84). DWR As-Built Specification No. 63-25, Sheet No. 4, 9 May 1963, (HLM 0.84)].

Levee crown looking downstream.

LS view: Toe from crown.

LS view: Slope and headwall at toe.

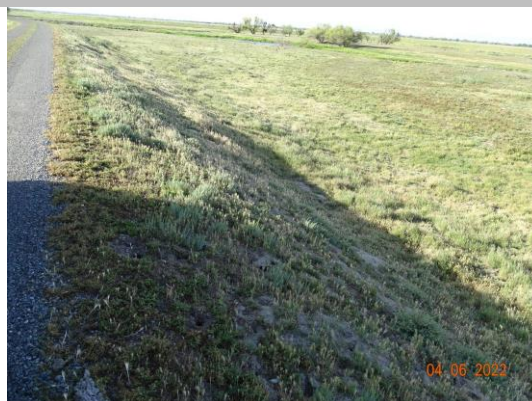
Photo 1 of 1 : SP_2022_NA0010_123_154_20220414_00364.jpg

LM Start	0.90	Rating **	A/W	Issue No.	154
LM End	0.90	Issue Type +	Ma	Location *	WS
Category	Earthen Levee			GPS Latitude/Longitude	
				Start	End
Item	Erosion / Livestock			37.271264 °	37.271264 °
				-120.811934 °	-120.811934 °
DWR ID	DWR_NA0010_05_s_2022_154				
Comment Code					
E4 : Repair the levee slope damaged by livestock and prevent large animal access.					
Inspector Comment					
Shallow depression on the lower 1/3 of the waterside slope. Possibly from livestock, but no visible trail leading to the depression.

View of minor slope erosion on the waterside. (Spring 2022)
