**Flood Control Project Maintenance
Levee Inspections
LMA District Cover Sheet**

Lower San Joaquin Levee District

**Flood Control Project Maintenance
Levee Inspections
Unit Cover Sheet**

Levee Inspection Report By Mile - Spring 2022

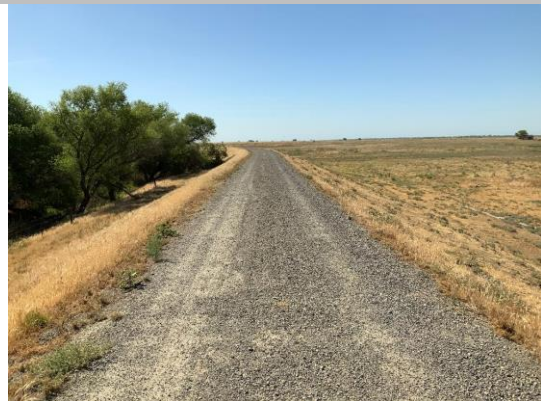
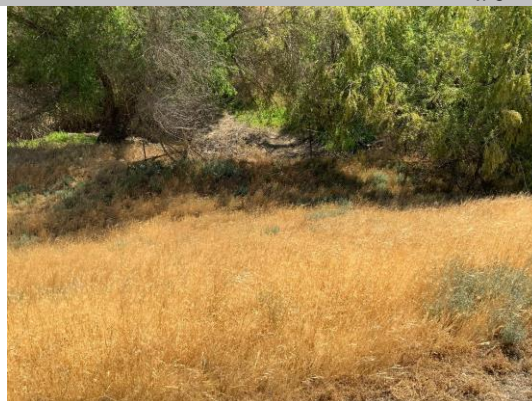
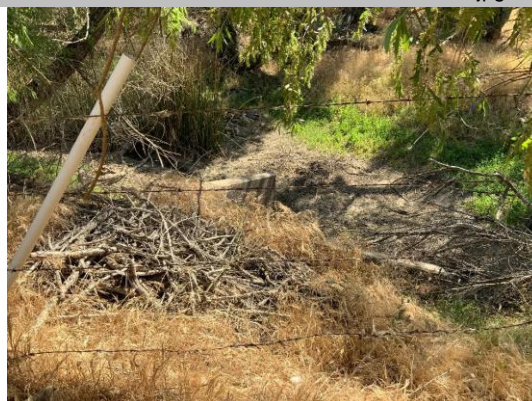
Photo 1 of 3 : UCIP_SP_2022_70989_99672.jpg

Comment Code						
Inspector Comment						
FS_ID:70989						
DS_ID:19760						
EP_NO: N/A						
Repair Type: Non-Urgent						
Crossing Status: Found						
UCIP Comments: 06/1/2021 The record has been upgraded from No Action Needed to Non-Urgent. LS pipe inlet blocked by barbed wire, could not inspect. Small pipe lodged in the WS flapgate so it cannot be closed all the way, recommend removal before flood season. No permit was found authorizing this encroachment. CVFPB will need to review crossing to determine owner. The UCIP inspection was completed with GEI staff, P. Espinoza. (H. Dunn ? GEI)						
FIELD_STRUCT_DESC: 36-inch corrugated metal gravity drainage pipe (CMP) through the levee, 21.0 feet below the crown. Flap gate on the waterside (WS) end. Concrete headwall on the landside (LS) end. Concrete U-shaped headwall on the WS end. [Additional Reference(s): DWR Levee Log, 2002, (HLM 1.44). USACE San Joaquin O&M Manual, Unit No. 601, Part No. 1, 1967, Amended in 1978, Revised 20 June 1985, (HLM 1.44). DWR As-Built Specification No. 63-25, Sheet No. 4, 9 May 1963, (HLM 1.44)].

Levee crown looking downstream.

LS view: Toe from crown.

LS view: Headwall barely visible at toe behind barbed wire.

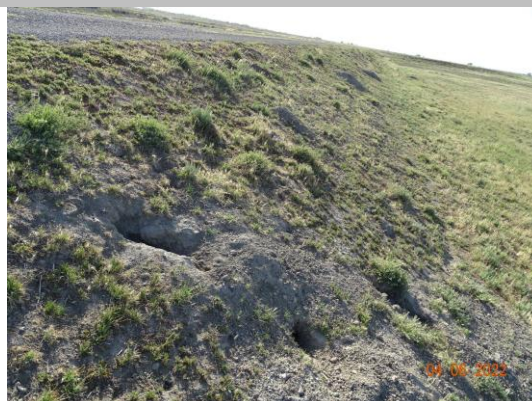
Photo 1 of 1 : SP_2022_NA0010_123_156_20220414_00365.jpg

LM Start	1.53	Rating **	U	Issue No.	156
LM End	1.53	Issue Type +	Ma	Location *	WS
Category	Earthen Levee			GPS Latitude/Longitude	
				Start	End
Item	Animal Control			37.265008 °	37.265008 °
				-120.804010 °	-120.804010 °
DWR ID	DWR_NA0010_05_s_2022_156				
Comment Code					
A3 : No rodents visible, but rodent burrows visible; need to backfill and compact or grout burrows.					
Inspector Comment					
Several rodent burrows observed. A few appear to penetrate the levee through to the landside.

Several rodent holes observed on the waterside slope. (Spring 2022)

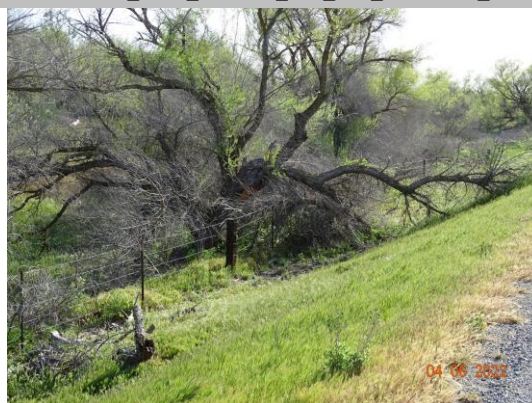
Photo 1 of 1 : SP_2022_NA0010_123_102_20220414_00366.jpg

LM Start	2.82	Rating **	M	Issue No.	102
LM End	2.82	Issue Type +	Ma	Location *	LS
Category	Earthen Levee			GPS Latitude/Longitude	
				Start	End
Item	Encroachments			37.256805 °	37.256805 °
				-120.785434 °	-120.785434 °
DWR ID	DWR_NA0010_05_s_2019_102				
Comment Code					
TR : Tree or limb					
Inspector Comment

Tree limb has fallen on the landside slope and toe. (Spring 2022)

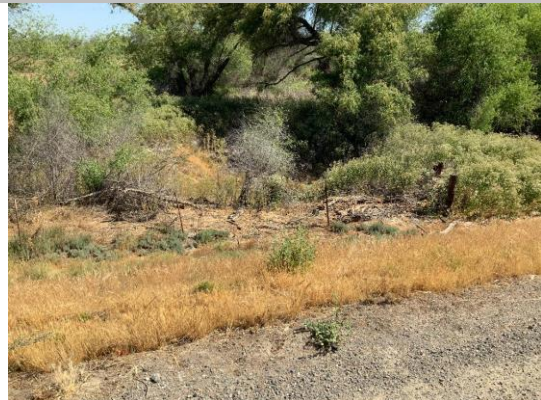
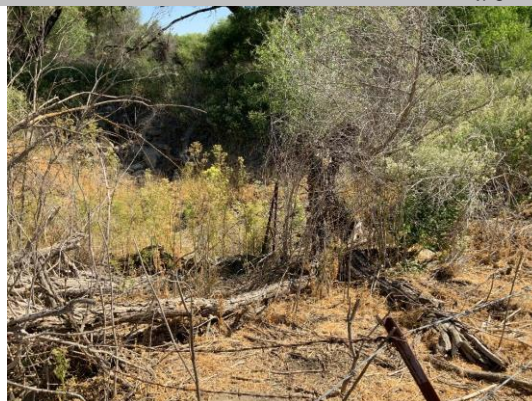
Photo 1 of 3 : UCIP_SP_2022_70990_99680.jpg

Comment Code					
Inspector Comment					
FS_ID:70990 DS_ID:19809 EP_NO: N/A Repair Type: Non-Urgent Crossing Status: Found UCIP Comments: 06/1/2021 Record remains Non-Urgent. DWR DMP internal inspection has found pipe integrity issues. LOF of crossing is between 4.1 and 5. Crossing will be monitored until funding becomes available for rehabilitation. Barbed wire over LS end, could not inspect. No permit was found authorizing this encroachment. CVFPB will need to review crossing to determine owner. The UCIP inspection was completed with GEI staff, P. Espinoza. (H. Dunn ? GEI) 04/09/2014 Log partially blocking inlet at LS toe. (W. Wylie - DWR UCIP) FIELD_STRUCT_DESC: 24-inch corrugated metal gravity drainage pipe (CMP) through the levee, 15.0 feet below the crown. Flap gate on the waterside (WS) end. Concrete U-shaped headwall on each end. [Additional Reference(s): DWR Levee Log, 2002, (HLM 2.83). USACE San Joaquin O&M Manual, Unit No. 601, Part No. 1, 1967, Amended in 1978, Revised 20 June 1985, (HLM 2.85). DWR As-Built Specification No. 63-25, Sheet No. 5, 9 May 1963, (HLM 2.85)]. FS Date: 6/1/2021

Levee crown looking downstream.

LS view: Toe from crown.

LS view: Headwall barely visible at toe behind barbed wire.

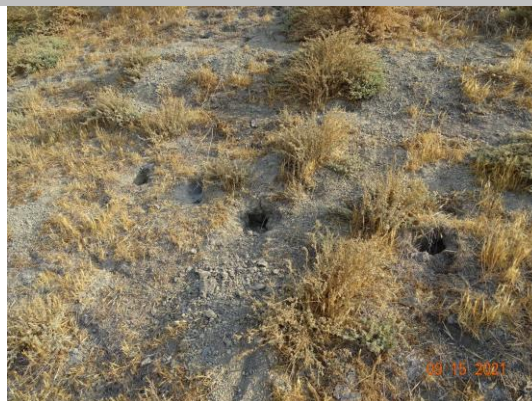
Photo 1 of 1 : SP_2022_NA0010_123_127_20220308_00027.jpg

LM Start	3.23	Rating **	A/W	Issue No.	127
LM End	3.23	Issue Type +	Ma	Location *	WS
Category	Earthen Levee			GPS Latitude/Longitude	
				Start	End
Item	Animal Control			37.256278 °	37.256278 °
				-120.778404 °	-120.778404 °
DWR ID	DWR_NA0010_05_s_2022_127				
Comment Code					
A3 : No rodents visible, but rodent burrows visible; need to backfill and compact or grout burrows.					
Inspector Comment

View of rodent holes in the water side slope. (Fall 2021)

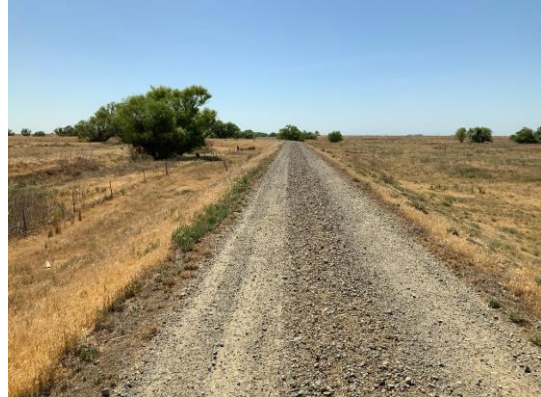
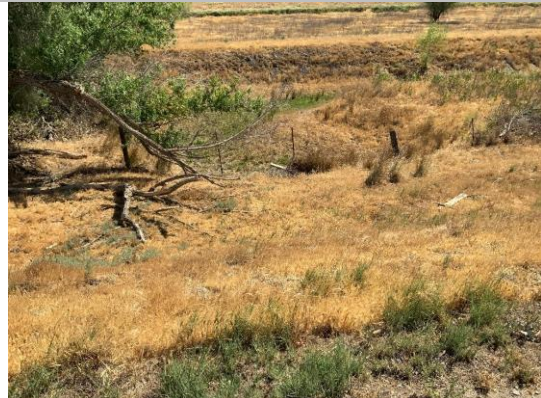
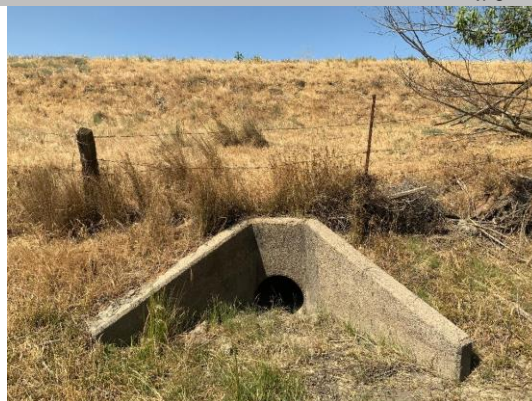
Photo 1 of 3 : UCIP_SP_2022_70991_99689.jpg

Comment Code						
Inspector Comment						
FS_ID:70991 DS_ID:19810 EP_NO: N/A Repair Type: Non-Urgent Crossing Status: Found UCIP Comments: 06/1/2021 Record remains Non-Urgent. DWR DMP internal inspection has found pipe integrity issues. LOF of crossing is between 4.1 and 5. Crossing will be monitored until funding becomes available for rehabilitation. Pipe is erroded through causing holes just behind the WS flapgate. Metal peeling away inside of pipe outlet. Flapgate is rusted with some corrosion. No permit was found authorizing this encroachment. CVFPB will need to review crossing to determine owner. The UCIP inspection was completed with GEI staff, P. Espinoza. (H. Dunn ? GEI) 04/15/2014 Pipe corroded through at flapgate on WS toe. (W. Wylie - DWR UCIP) FIELD_STRUCT_DESC: 24-inch corrugated metal gravity drainage pipe (CMP) through the levee, 14.7 feet below the crown. Flap gate on the waterside (WS) end. Concrete U-shaped headwall on each end. [Additional Reference(s): DWR Levee Log, 2002, (HLM 3.36). USACE San Joaquin O&M Manual, Unit No. 601, Part No. 1, 1967, Amended in 1978, Revised 20 June 1985, (HLM 3.33). DWR As-Built Specification No. 63-25, Sheet No. 5, 9 May 1963, (HLM 3.33)]. FS Date: 6/1/2021

Levee crown looking downstream.

LS view: Toe from crown.

LS view: Slope and headwall at toe.

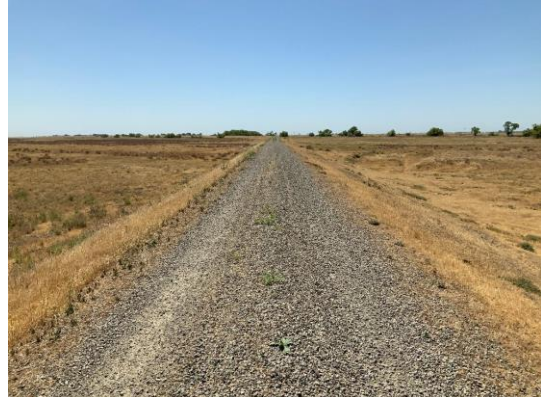
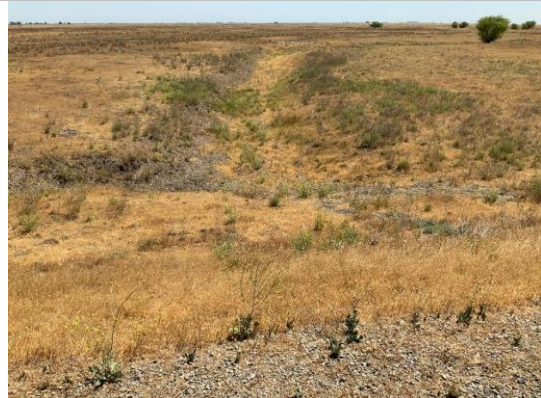
Photo 1 of 3 : UCIP_SP_2022_70992_99696.jpg

Comment Code					
Inspector Comment					
FS_ID:70992 DS_ID:19811 EP_NO: N/A Repair Type: Non-Urgent Crossing Status: Found UCIP Comments: 06/1/2021 Record remains Non-Urgent. Some debris buildup within the LS pipe inlet, recommend cleaning out. No permit was found authorizing this encroachment. CVFPB will need to review crossing to determine owner. The UCIP inspection was completed with GEI staff, P. Espinoza. (H. Dunn ? GEI) 04/16/2014 Sediment buildup in pipe visible from landward side--recommend contacting owner to clear pipe. (W. Wylie - DWR UCIP) FIELD_STRUCT_DESC: 24-inch corrugated metal gravity drainage pipe (CMP) through the levee, 15.0 feet below the crown. Flap gate on the waterside (WS) end. Concrete headwall on the landside (LS) end. Concrete U-shaped headwall on the WS end. [Additional Reference(s): DWR Levee Log, 2002, (HLM 3.67). USACE San Joaquin O&M Manual, Unit No. 601, Part No. 1, 1967, Amended in 1978, Revised 20 June 1985, (HLM 3.67). DWR As-Built Specification No. 63-25, Sheet No. 6, 9 May 1963, (HLM 3.67)]. FS Date: 6/1/2021

Levee crown looking downstream.

LS view: Toe from crown.

LS view: Slope and headwall at toe.

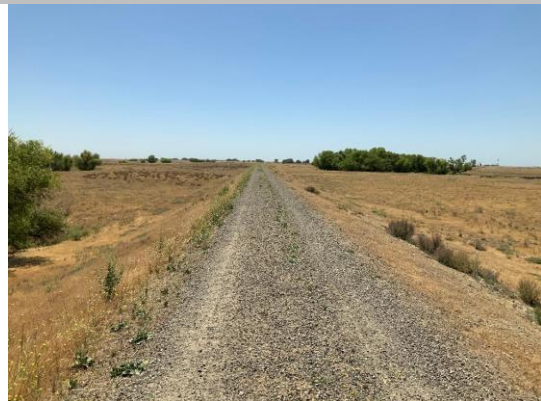
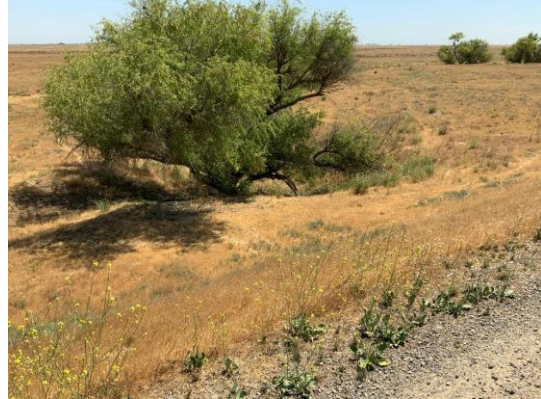
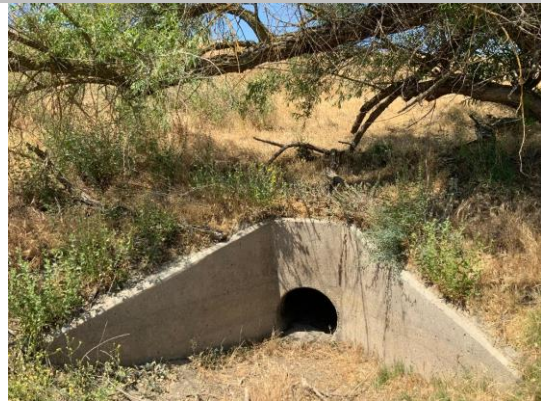
Photo 1 of 3 : UCIP_SP_2022_70993_99704.jpg

FS_ID:70993
DS_ID:19769
EP_NO: N/A
Repair Type: Non-Urgent
Crossing Status: Found
UCIP Comments: 06/1/2021 Record remains Non-Urgent. Some sediment buildup in LS pipe inlet, recommend cleaning out. No permit was found authorizing this encroachment. CVFPB will need to review crossing to determine owner. The UCIP inspection was completed with GEI staff, P. Espinoza. (H. Dunn ? GEI) 04/16/2014 Sediment buildup in pipe visible from landward side--recommend contacting owner to clear pipe. (W. Wylie - DWR UCIP)
FIELD_STRUCT_DESC: 24-inch corrugated metal gravity drainage pipe (CMP) through the levee, 16.0 feet below the crown. Flap gate on the waterside (WS) end. Concrete U-shaped headwall on each end. [Additional Reference(s): DWR Levee Log, 2002, (HLM 4.01). USACE San Joaquin O&M Manual, Unit No. 601, Part No. 1, 1967, Amended in 1978, Revised 20 June 1985, (HLM 4.02). DWR As-Built Specification No. 63-25, Sheet No. 6, 9 May 1963, (HLM 4.02)].

Levee crown looking downstream.

LS view: Toe from crown.

LS view: Slope and headwall at toe.

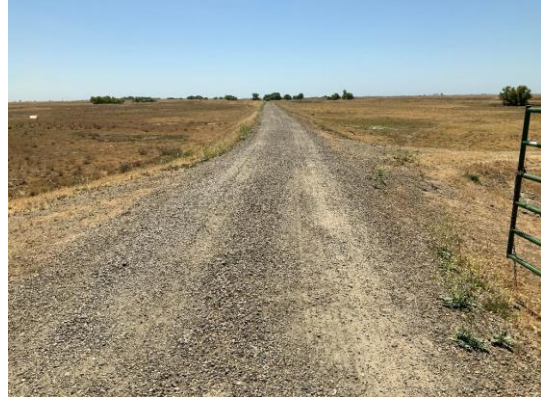
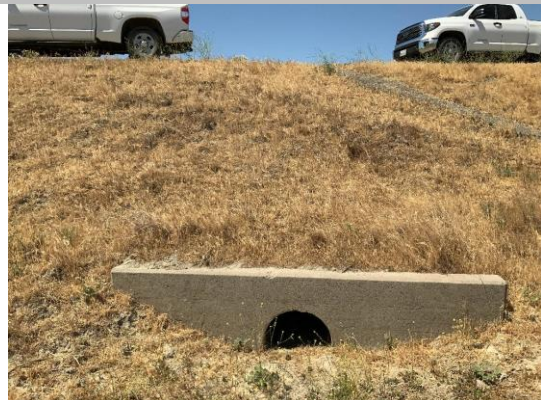
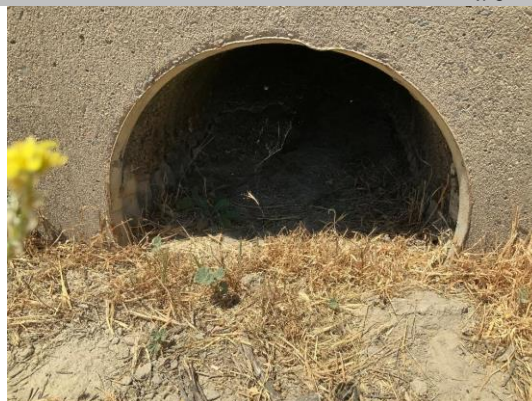
Comment Code						
Inspector Comment						
FS_ID:70994						
DS_ID:19770						
EP_NO: N/A						
Repair Type: Non-Urgent						
Crossing Status: Found						
UCIP Comments: 06/1/2021 Record remains Non-Urgent. Sizable burrow complex on WS slope, with several holes around 3-4 inches wide, recommend filling in for levee integrity. There is also sediment buildup within the LS pipe inlet, recommend cleaning out. No permit was found authorizing this encroachment. CVFPB will need to review crossing to determine owner. The UCIP inspection was completed with GEI staff, P. Espinoza. (H. Dunn ? GEI) 04/16/2014 Sediment buildup in pipe visible from landward side--recommend contacting owner to clear pipe. (W. Wylie - DWR UCIP)						
FIELD_STRUCT_DESC: 24-inch corrugated metal gravity drainage pipe (CMP) through the levee, 11.6 feet below the crown. Flap gate on the waterside (WS) end. Concrete headwall on the landside (LS) end. Concrete U-shaped headwall on the WS end. [Additional Reference(s): DWR Levee Log, 2002, (HLM 4.27). USACE San Joaquin O&M Manual, Unit No. 601, Part No. 1, 1967, Amended in 1978, Revised 20 June 1985, (HLM 4.27). DWR As-Built Specification No. 63-25, Sheet No. 6, 9 May 1963, (HLM 4.27)].

Levee crown looking downstream.

LS view: Slope and headwall at toe.

LS view: Close up of pipe inlet with sediment buildup at toe.

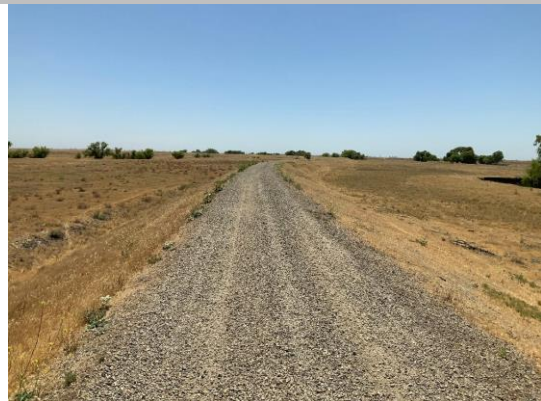
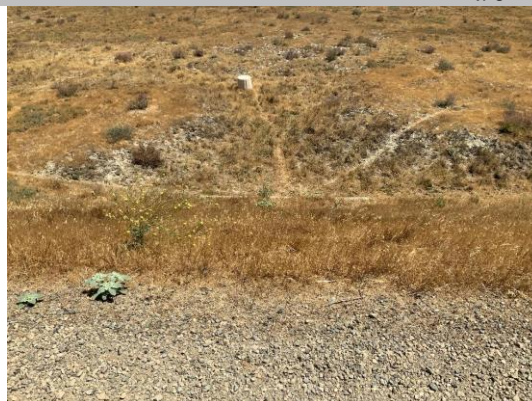
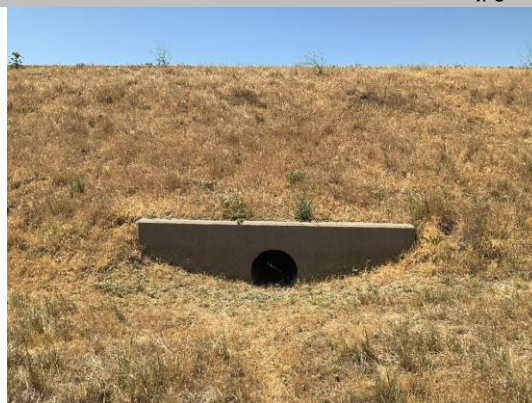
Comment Code					
Inspector Comment					
FS_ID:70995 DS_ID:19771 EP_NO: N/A Repair Type: Non-Urgent Crossing Status: Found UCIP Comments: 06/1/2021 Record remains Non-Urgent. LS pipe inlet has sediment buildup inside, recommend cleaning out. No permit was found authorizing this encroachment. CVFPB will need to review crossing to determine owner. The UCIP inspection was completed with GEI staff, P. Espinoza. (H. Dunn ? GEI) 04/16/2014 Sediment buildup in pipe visible from landward side--recommend contacting owner to clear pipe. (W. Wylie - DWR UCIP) FIELD_STRUCT_DESC: 24-inch corrugated metal gravity drainage pipe (CMP) through the levee, 12.0 feet below the crown. Flap gate on the waterside (WS) end. Concrete headwall on the landside (LS) end. Concrete U-shaped headwall on the WS end. [Additional Reference(s): DWR Levee Log, 2002, (HLM 4.53). USACE San Joaquin O&M Manual, Unit No. 601, Part No. 1, 1967, Amended in 1978, Revised 20 June 1985, (HLM 4.54). DWR As-Built Specification No. 63-25, Sheet No. 6, 9 May 1963, (HLM 4.54)]. FS Date: 6/1/2021

Levee crown looking downstream.

LS view: Toe from crown.

LS view: Slope and headwall at toe.

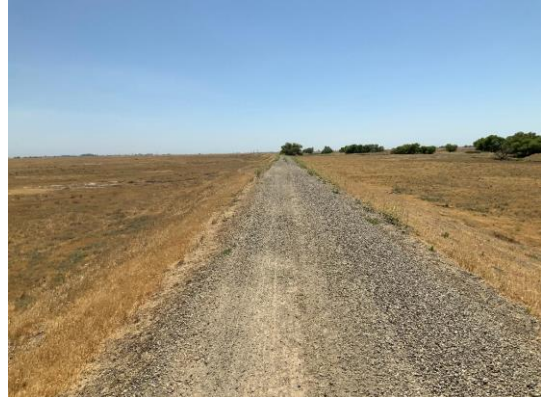
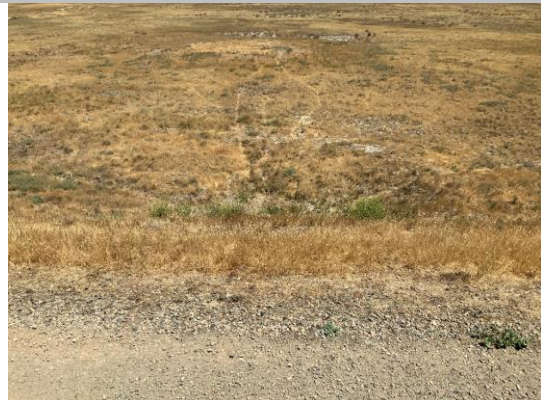
Comment Code						
Inspector Comment						
FS_ID:70996 DS_ID:19772 EP_NO: N/A Repair Type: Non-Urgent Crossing Status: Found UCIP Comments: 06/1/2021 The record remains Non-Urgent. LS pipe inlet has sediment buildup, recommend cleaning out. No permit was found authorizing this encroachment. CVFPB will need to review crossing to determine owner. The UCIP inspection was completed with GEI staff, P. Espinoza. (H. Dunn ? GEI) 04/16/2014 Heavy sediment buildup in pipe visible from landward side--recommend contacting owner to clear pipe. (W. Wylie - DWR UCIP) FIELD_STRUCT_DESC: 24-inch corrugated metal gravity drainage pipe (CMP) through the levee, 12.3 feet below the crown. Flap gate on the waterside (WS) end. Concrete headwall on the landside (LS) end. Concrete U-shaped headwall on the WS end. [Additional Reference(s): DWR Levee Log, 2002, (HLM 4.89). USACE San Joaquin O&M Manual, Unit No. 601, Part No. 1, 1967, Amended in 1978, Revised 20 June 1985, (HLM 4.89). DWR As-Built Specification No. 63-25, Sheet No. 7, 9 May 1963, (HLM 4.89)]. FS Date: 6/1/2021

Levee crown looking downstream.

LS view: Toe from crown.

LS view: Slope and headwall at toe.

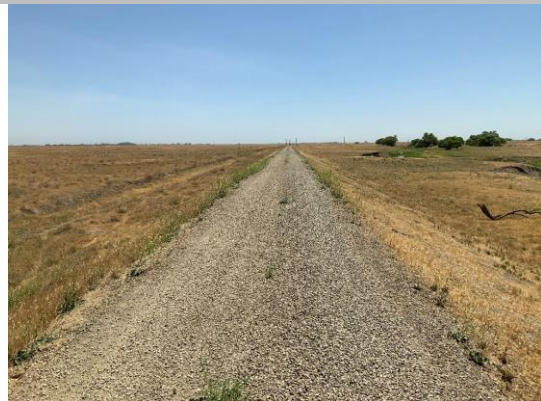
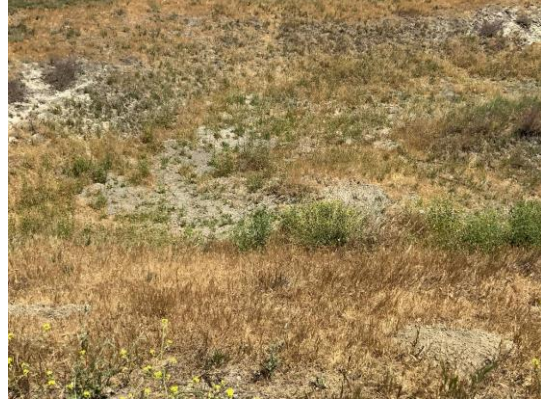
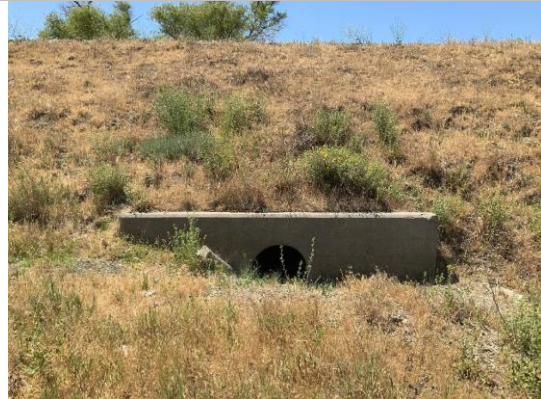
FS_ID:70997
DS_ID:19773
EP_NO: N/A
Repair Type: Non-Urgent
Crossing Status: Found
UCIP Comments: 06/1/2021 The record remains Non-Urgent. Crossing appears to be in good condition. No permit was found authorizing this encroachment. CVFPB will need to review crossing to determine owner. The UCIP inspection was completed with GEI staff, P. Espinoza. (H. Dunn ? GEI) 04/16/2014 Heavy sediment buildup in pipe visible from landward side--recommend contacting owner to clear pipe. (W. Wylie - DWR UCIP)
FIELD_STRUCT_DESC: 24-inch corrugated metal gravity drainage pipe (CMP) through the levee, 12.2 feet below the crown. Flap gate on the waterside (WS) end. Concrete headwall on the landside (LS) end. Concrete U-shaped headwall on the WS end. [Additional Reference(s): DWR Levee Log, 2002, (HLM 5.14). USACE San Joaquin O&M Manual, Unit No. 601, Part No. 1, 1967, Amended in 1978, Revised 20 June 1985, (HLM 5.15). DWR As-Built Specification No. 63-25, Sheet No. 7, 9 May 1963, (HLM 5.15)].

Levee crown looking upstream.

LS view: Toe from crown.

LS view: Slope and headwall at toe.

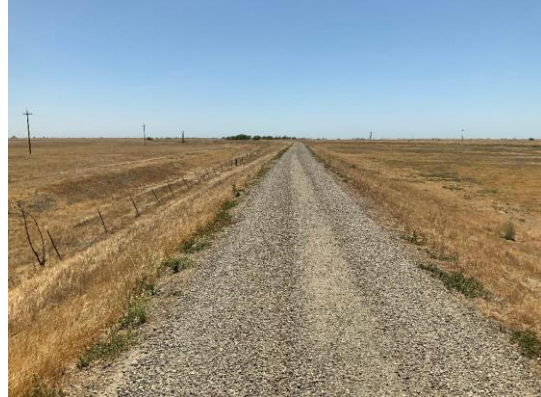
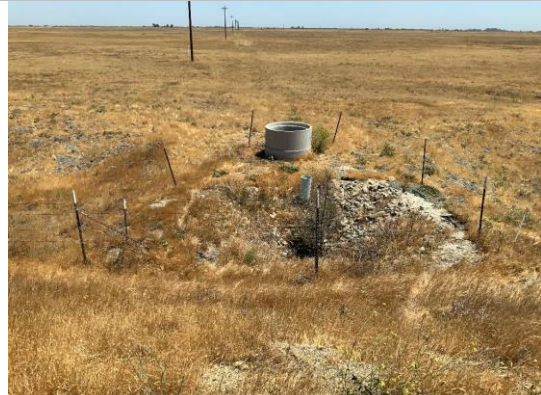
Comment Code						
Inspector Comment						
FS_ID:70998						
DS_ID:19774						
EP_NO: N/A						
Repair Type: Non-Urgent						
Crossing Status: Found						
UCIP Comments: 06/1/2021 The record has been upgraded from No						
Action Needed to Non-Urgent. Crossing appears to be in good						
condition. No permit was found authorizing this encroachment. CVFPB						
will need to review crossing to determine owner. New concrete riser,						
plastic riser, and flowmeter off the LS toe going away from the levee.						
The UCIP inspection was completed with GEI staff, P. Espinoza. (H.						
Dunn ? GEI)						
FIELD_STRUCT_DESC: 24-inch corrugated metal gravity drainage						
pipe (CMP) through the levee, 9.5 feet below the crown. Flap gate on						
the waterside (WS) end. Concrete headwall on the landside (LS) end.						
Concrete U-shaped headwall on the WS end. [Additional Reference(s):						
DWR Levee Log, 2002, (HLM 5.58). USACE San Joaquin O&M

Levee crown looking upstream.

LS view: Toe from crown.

LS view: Slope from toe.

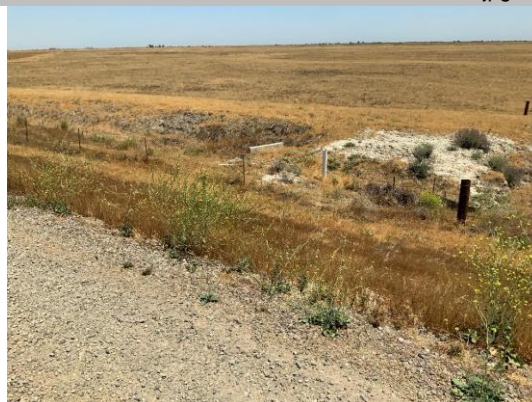
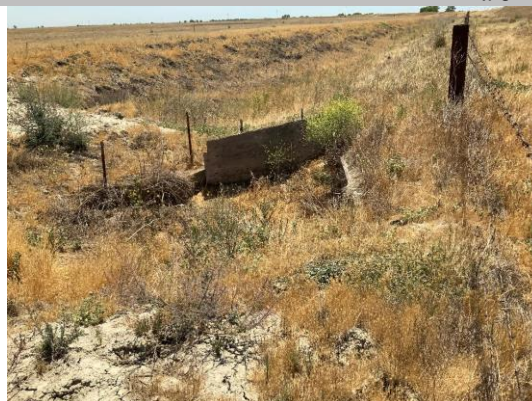
Comment Code					
Inspector Comment					
FS_ID:70999 DS_ID:19775 EP_NO: N/A Repair Type: Non-Urgent Crossing Status: Found UCIP Comments: 06/1/2021 The record has been upgraded from No Action Needed to Non-Urgent. LS inlet blocked by barbed wire and was inaccessible, could not inspect. No permit was found authorizing this encroachment. CVFPB will need to review crossing to determine owner. The UCIP inspection was completed with GEI staff, P. Espinoza. (H. Dunn ? GEI) FIELD_STRUCT_DESC: 24-inch corrugated metal gravity drainage pipe (CMP) through the levee, 13.0 feet below the crown. Flap gate on the waterside (WS) end. Concrete headwall on the landside (LS) end. Concrete U-shaped headwall on the WS end. [Additional Reference(s): DWR Levee Log, 2002, (HLM 6.35). USACE San Joaquin O&M Manual, Unit No. 601, Part No. 1, 1967, Amended in 1978, Revised 20 June 1985, (HLM 6.35). DWR As-Built Specification No. 63-25, Sheet No. 8, 9 May 1963, (HLM 6.35)]. FS Date: 6/1/2021

Levee crown looking upstream.

LS view: Toe from crown.

LS view: Headwall visible at toe behind barbed wire.

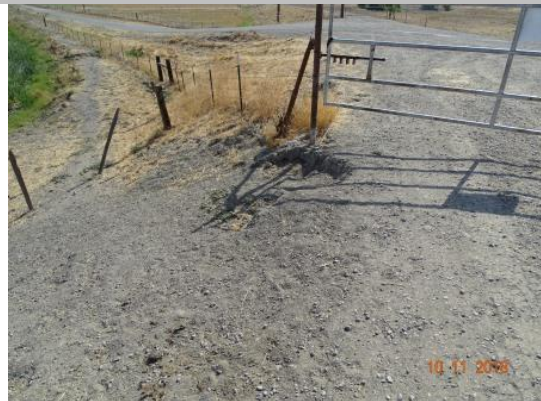
Photo 1 of 1 : SP_2022_NA0010_123_140_20220308_00036.jpg

LM Start	6.56	Rating **	A/W	Issue No.	140
LM End	6.56	Issue Type +	Ma	Location *	LS
Category	Earthen Levee			GPS Latitude/Longitude	
				Start	End
Item	Erosion / Livestock			37.230013 °	37.230013 °
				-120.726832 °	-120.726832 °
DWR ID	DWR_NA0010_05_f_2018_140				
Comment Code					
E4 : Repair the levee slope damaged by livestock and prevent large animal access.					
Inspector Comment					
Erosion onslope near the gate has been repaired with loose material. Monitor for settlement.

Erosion on landward slope caused by foot traffic. (Fall 2018)

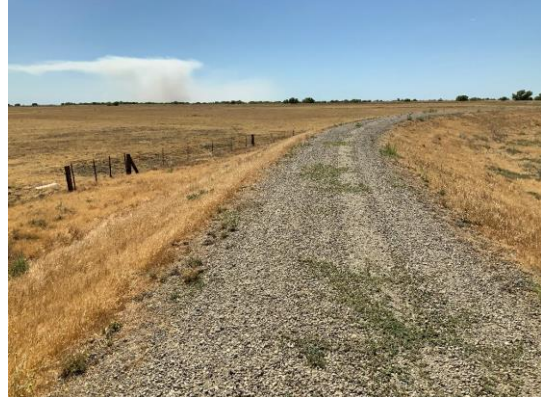
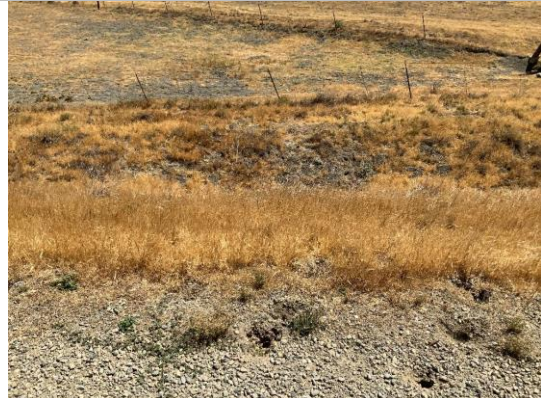
Comment Code						
Inspector Comment						
FS_ID:71000 DS_ID:19761 EP_NO: N/A Repair Type: Non-Urgent Crossing Status: Found UCIP Comments: 06/9/2021 The record remains Non-Urgent. Sediment buildup in LS pipe inlet, recommend removal. No permit was found authorizing this encroachment. CVFPB will need to review crossing to determine owner. The UCIP inspection was completed with GEI staff, P. Espinoza. (H. Dunn ? GEI) 04/22/2014 Sediment buildup in pipe visible from landward side--recommend contacting owner to clear pipe. (W. Wylie - DWR UCIP) FIELD_STRUCT_DESC: 24-inch corrugated metal gravity drainage pipe (CMP) through the levee, 12.0 feet below the crown. Flap gate on the waterside (WS) end. Concrete headwall on the landside (LS) end. Concrete U-shaped headwall on the WS end. [Additional Reference(s): DWR Levee Log, 2002, (HLM 7.36). USACE San Joaquin O&M Manual, Unit No. 601, Part No. 1, 1967, Amended in 1978, Revised 20 June 1985, (HLM 7.36). DWR As-Built Specification No. 63-25, Sheet No. 8, 9 May 1963, (HLM 7.36)]. FS Date: 6/9/2021

Levee crown looking upstream.

LS view: Toe from crown.

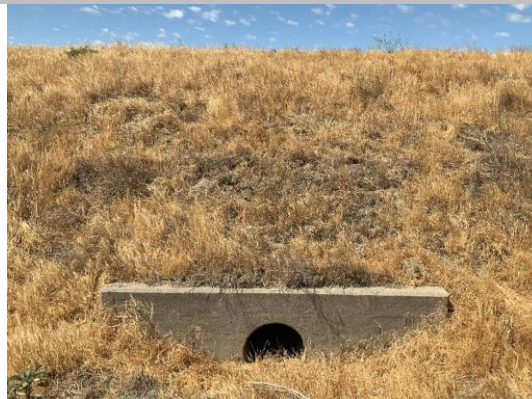
Photo 3 of 3 : UCIP_SP_2022_71000_100778.jpg

LS view: Slope and headwall at toe.

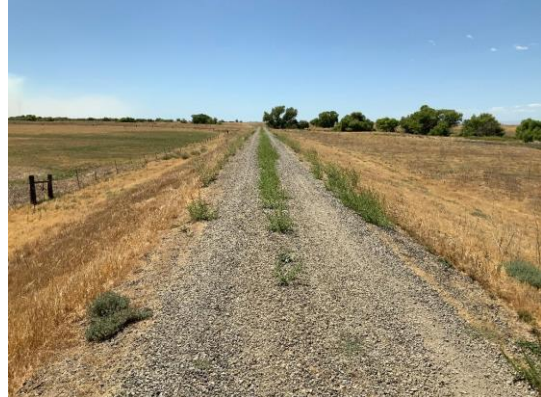
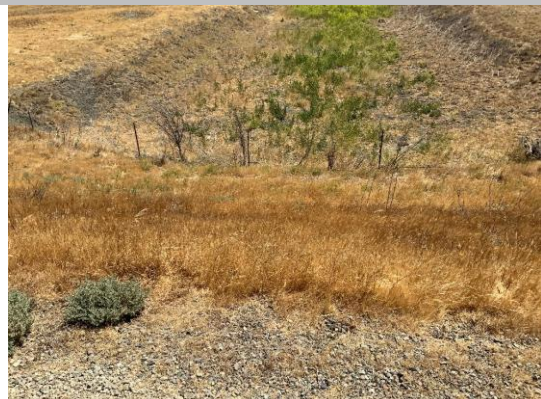
FS_ID:71001
DS_ID:19762
EP_NO: N/A
Repair Type: Non-Urgent
Crossing Status: Indicator Found
UCIP Comments: 06/9/2021 The record remains Non-Urgent. No pipe visible on WS or LS during inspection, only indicator found. WS metal riser is bent. DWR DMP Geophysical study indicates possible presence of pipe through levee at (2305907, -13523234), coordinates have been updated. Owner needs to coordinate with the CVFPB to remove or abandon crossing according to Title 23 requirements. No permit was found authorizing this encroachment. CVFPB will need to review crossing to determine owner. The UCIP inspection was completed with GEI staff, P. Espinoza. (H. Dunn ? GEI) 04/22/2014 Appears abandoned and if so should be done so properly. Slide gate rusted shut on WS slope. Unable to locate inlet or outlet. (W. Wylie - DWR UCIP)
FIELD_STRUCT_DESC: 24-inch corrugated metal gravity drainage pipe (CMP) through the levee, 20.4 feet below the crown. Slide gate in a 36-inch CMP riser unit on the waterside (WS) slope. Concrete U-shaped headwall on each end. [Additional Reference(s): DWR Levee Log, 2002, (HLM 7.57). USACE San Joaquin O&M Manual, Unit No. 601, Part No. 1, 1967, Amended in 1978, Revised 20 June 1985, (HLM 7.58). DWR As-Built Specification No. 63-25, Sheet No. 9, 9 May 1963, (HLM 7.58)].

LS view: Slope from toe, no pipe visible.

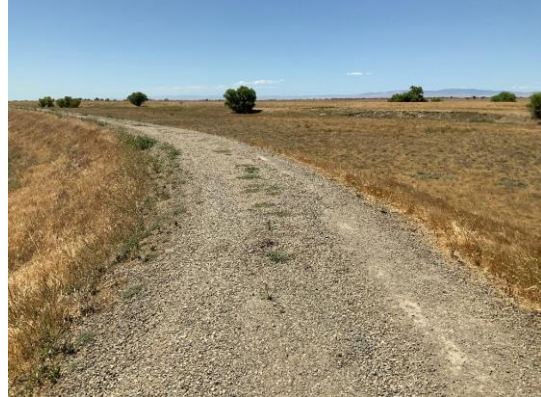
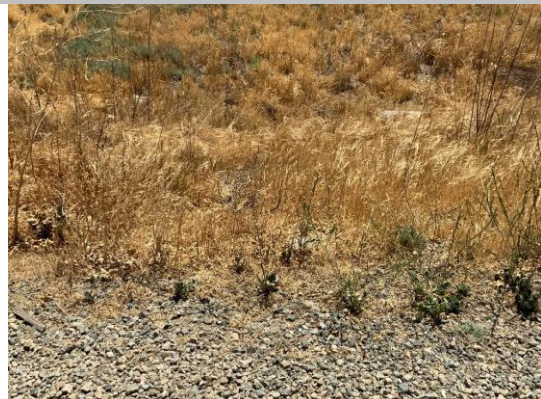
FS_ID:71002
DS_ID:19844
EP_NO: N/A
Repair Type: Non-Urgent
Crossing Status: Found
UCIP Comments: 06/9/2021 The record has been upgraded from No Action Needed to Non-Urgent. DWR DMP internal inspection has not found pipe integrity issues. LOF of crossing is less or equal to 4.0. Recommend next video inspection in 5 years. No permit was found authorizing this encroachment. CVFPB will need to review crossing to determine owner. The UCIP inspection was completed with GEI staff, P. Espinoza. (H. Dunn ? GEI) 08/01/2018 USACE O&M manual has pipe listed under Unit 10 HLM 0.02, however, based on the current levee alignment pipe is located under Unit 5 CLM 7.68. Discrepancy in pipe O&M reference is based on reference between Historic Levee Alignment and Current Levee Alignment. (DWR UCIP - O. Magana)
FIELD_STRUCT_DESC: 24-inch corrugated metal gravity drainage pipe (CMP) through the levee, 9.4 feet below the crown. Flap gate on the waterside (WS) end. Concrete headwall on the landside (LS) end. Concrete U-shaped headwall on the WS end. [Additional Reference(s): DWR Levee Log, 2002. USACE San Joaquin O&M Manual, Unit No. 601, Part No. 1, 1967, Amended in 1978, Revised 20 June 1985, (recorded as Unit 10 HLM 0.02, located in Unit 5 CLM 7.68)].

LS view: Slope and headwall at toe.

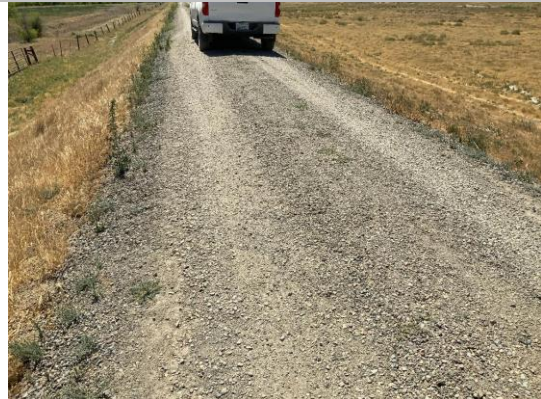
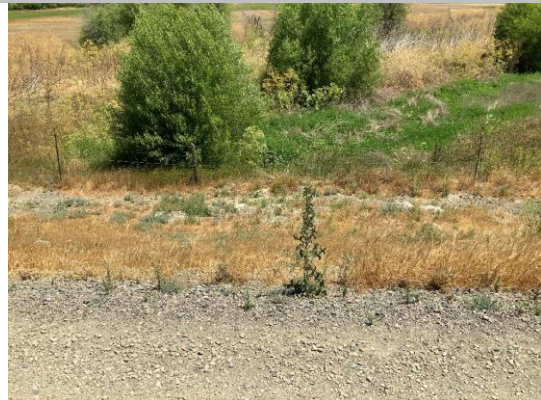
Comment Code						
Inspector Comment						
FS_ID:71003 DS_ID:19763 EP_NO: N/A Repair Type: Non-Urgent Crossing Status: Found UCIP Comments: 06/9/2021 The record remains Non-Urgent. Barbed wire over LS pipe inlet, limited inspection due to inaccessability. No permit was found authorizing this encroachment. CVFPB will need to review crossing to determine owner. The UCIP inspection was completed with GEI staff, P. Espinoza. (H. Dunn ? GEI) 04/22/2014 Pipe filled with silt on LS toe and should be cleared. (W. Wylie - DWR UCIP) FIELD_STRUCT_DESC: 24-inch corrugated metal gravity drainage pipe (CMP) through the levee, 16.0 feet below the crown. Flap gate on the waterside (WS) end. Concrete headwall on the landside (LS) end. Concrete U-shaped headwall on the WS end. [Additional Reference(s): DWR Levee Log, 2002, (HLM 8.45). USACE San Joaquin O&M Manual, Unit No. 601, Part No. 1, 1967, Amended in 1978, Revised 20 June 1985, (HLM 8.44). DWR As-Built Specification No. 63-25, Sheet No. 9, 9 May 1963, (HLM 8.44)]. FS Date: 6/9/2021

LS view: Slidegate visible at the toe behind barbed wire.

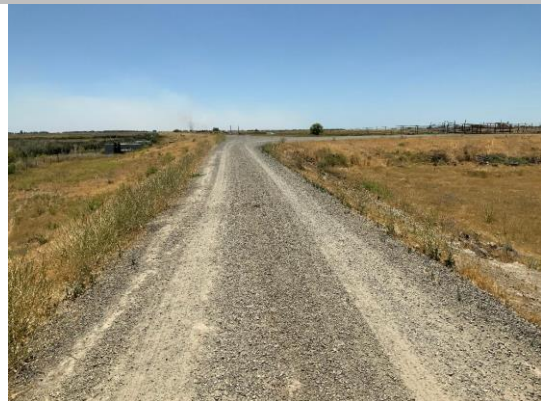
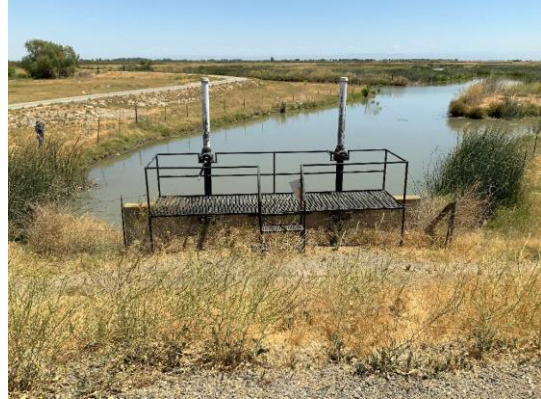
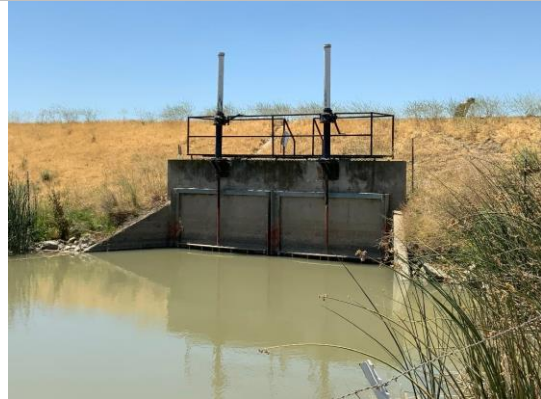
FS_ID:71004
DS_ID:19764
EP_NO: N/A
Repair Type: Non-Urgent
Crossing Status: Found
UCIP Comments: 06/9/2021 The record has been upgraded from No Action Needed to Non-Urgent. Limited inspection of WS and LS due to slidegates and inlets being underwater at the time of inspection. No permit was found authorizing this encroachment. CVFPB will need to review crossing to determine owner. The UCIP inspection was completed with GEI staff, P. Espinoza. (H. Dunn ? GEI) 10/27/2017
This structure is inspected annually under the Structure and Channel Summer Inspection (part of the Levee Inspection Program) conducted by the DWR Flood Project Integrity and Inspection Branch (FPIIB). (O. Magana - DWR UCIP)
FIELD_STRUCT_DESC: [Deadman Creek Drainage Ditch Structure] 1 of 2: 48-inch by 102-inch reinforced concrete box gravity drainage culvert (RCBC) through the levee, 13.8 feet below the crown. Concrete U-shaped headwall on the waterside (WS) end. Concrete headwall on the landside (LS) end, with a slide gate mounted on the headwall. WS slope and outlet drain cobble revetted. [Additional Reference(s): DWR Levee Log, 2002, (HLM 8.83). USACE San Joaquin O&M Manual, Unit No. 601, Part No. 1, 1967, Amended in 1978, Revised 20 June 1985, (HLM 8.83). DWR As-Built Specification No. 63-25, Sheet No. 10, 9 May 1963, (HLM 8.83)].

LS view: Slope and slidegates from toe.

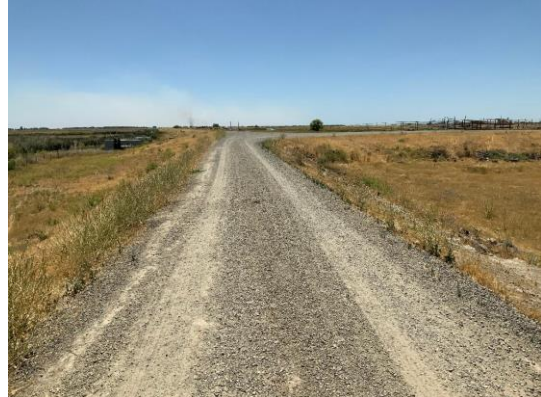
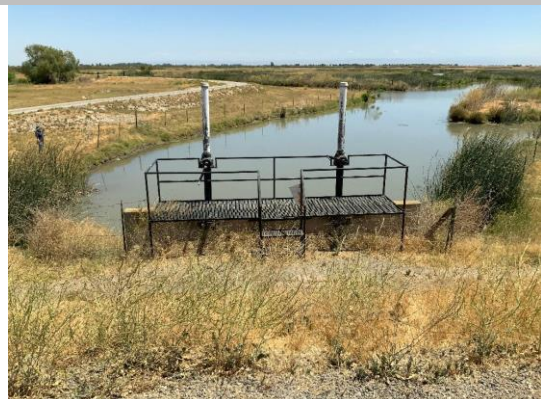
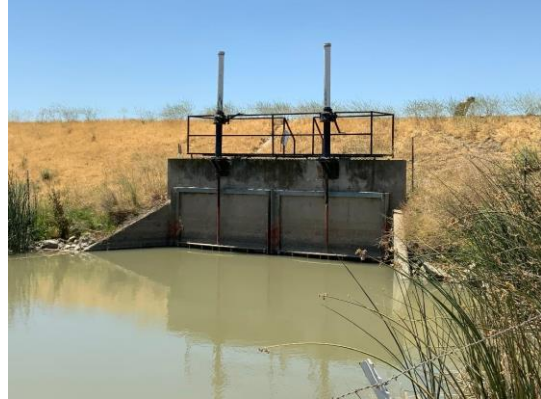
FS_ID:71005
DS_ID:19735
EP_NO: N/A
Repair Type: Non-Urgent
Crossing Status: Found
UCIP Comments: 06/9/2021 The record has been upgraded from No Action Needed to Non-Urgent. Limited inspection of LS and WS due to slidegate and inlet being underwater during inspection. No permit was found authorizing this encroachment. CVFPB will need to review crossing to determine owner. The UCIP inspection was completed with GEI staff, P. Espinoza. (H. Dunn ? GEI) 10/27/2017 This structure is inspected annually under the Structure and Channel Summer Inspection (part of the Levee Inspection Program) conducted by the DWR Flood Project Integrity and Inspection Branch (FPIIB). (O. Magana - DWR UCIP)
FIELD_STRUCT_DESC: [Deadman Creek Drainage Ditch Structure] 2 of 2: 48-inch by 102-inch reinforced concrete box gravity drainage culvert (RCBC) through the levee, 13.8 feet below the crown. Concrete U-shaped headwall on the waterside (WS) end. Concrete headwall on the landside (LS) end, with a slide gate mounted on the headwall. WS slope and outlet drain cobble revetted. [Additional Reference(s): DWR Levee Log, 2002, (HLM 8.83). USACE San Joaquin O&M Manual, Unit No. 601, Part No. 1, 1967, Amended in 1978, Revised 20 June 1985, (HLM 8.83). DWR As-Built Specification No. 63-25, Sheet No. 10, 9 May 1963, (HLM 8.83)].

LS view: Slidegates and slope from toe.

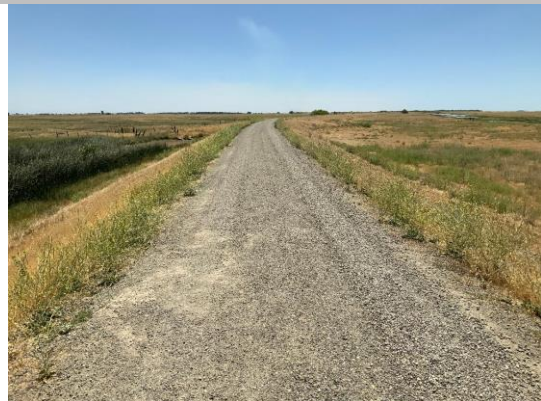
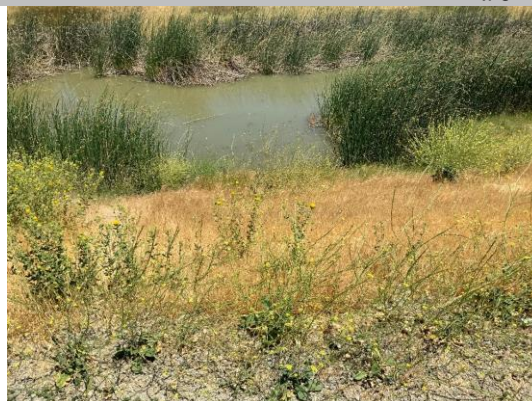
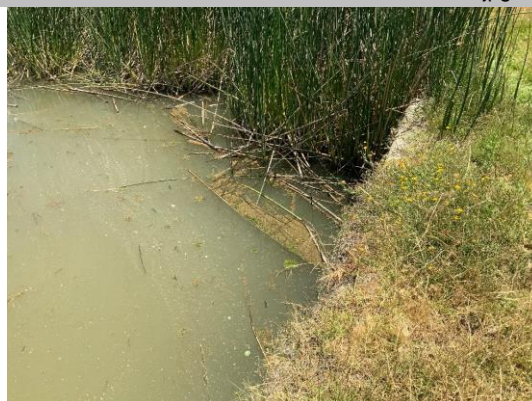
FS_ID:71009
DS_ID:19766
EP_NO: N/A
Repair Type: Non-Urgent
Crossing Status: Found
UCIP Comments: 06/9/2021 The record has been upgraded from No Action Needed to Non-Urgent. LS pipe inlet was underwater during inspection, limited inspection. WS riser is missing half of the cover causing safety hazard. The LS pipe inlet is filled with sediment, recommend removal. No permit was found authorizing this encroachment. CVFPB will need to review crossing to determine owner. The UCIP inspection was completed with GEI staff, P. Espinoza. (H. Dunn ? GEI)
FIELD_STRUCT_DESC: 36-inch corrugated metal gravity drainage pipe (CMP) through the levee, 14.8 feet below the crown. Slide gate in a 48-inch CMP riser unit on the waterside (WS) slope. Concrete headwall on each end. [Additional Reference(s): DWR Levee Log, 2002, (HLM 9.24). USACE San Joaquin O&M Manual, Unit No. 601, Part No. 1, 1967, Amended in 1978, Revised 20 June 1985, (HLM 9.26). DWR As-Built Specification No. 61-01, Sheet No. 52, 7 March 1961, (HLM 9.26)].

LS view: Headwall visible at toe, pipe is underwater.

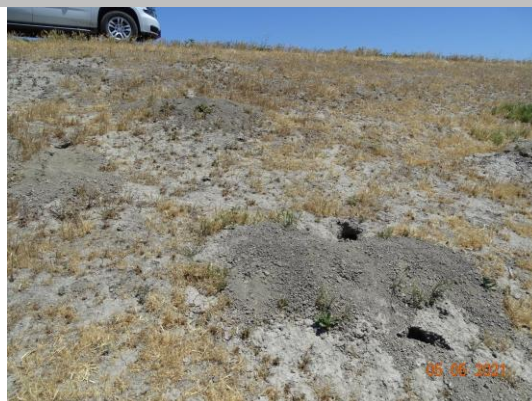
Photo 1 of 1 : SP_2022_NA0010_123_101_20220308_00011.jpg

LM Start	9.41	Rating **	M	Issue No.	101
LM End	9.45	Issue Type +	Ma	Location *	WS
Category	Earthen Levee			GPS Latitude/Longitude	
				Start	End
Item	Animal Control			37.201636 °	37.201240 °
				-120.688154 °	-120.687686 °
DWR ID	DWR_NA0010_05_s_2021_101				
Comment Code					
A3 : No rodents visible, but rodent burrows visible; need to backfill and compact or grout burrows.					
Inspector Comment

Multiple rodent holes in the waterside slope. (Spring 2021)

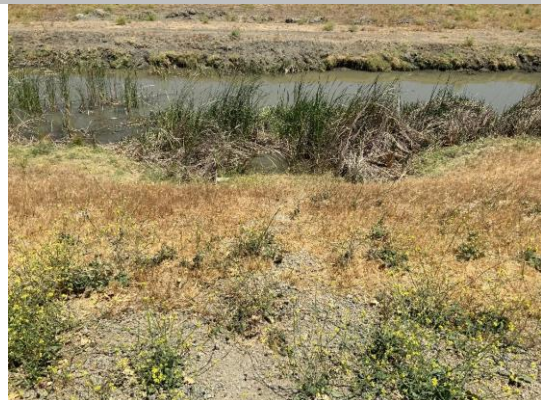
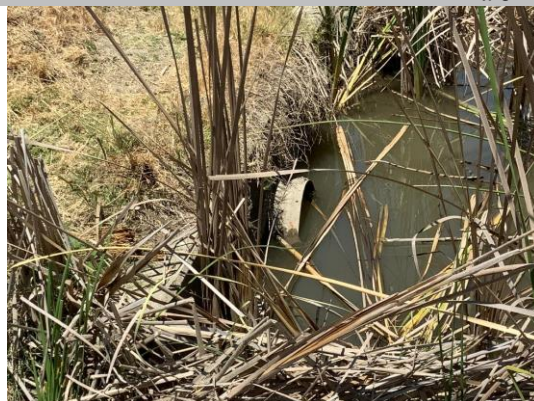
Comment Code					
Inspector Comment					
FS_ID:71010 DS_ID:19767 EP_NO: N/A Repair Type: Non-Urgent Crossing Status: Found UCIP Comments: 06/9/2021 The record remains Non-Urgent. LS pipe inlet is underwater, could not inspect. No permit was found authorizing this encroachment. CVFPB will need to review crossing to determine owner. The UCIP inspection was completed with GEI staff, P. Espinoza. (H. Dunn ? GEI) 04/22/2014 Slidegate actuator appears bent and may not work properly (WS slope). (W. Wylie - DWR UCIP) FIELD_STRUCT_DESC: 24-inch corrugated metal gravity drainage pipe (CMP) through the levee, 15.0 feet below the crown. Slide gate in a 36-inch CMP riser unit on the waterside (WS) slope. Concrete headwall on each end. [Additional Reference(s): DWR Levee Log, 2002 (HLM 10.04). USACE San Joaquin O&M Manual, Unit No. 601, Part No. 1, 1967, Amended in 1978, Revised 20 June 1985, (HLM 10.05). DWR As-Built Specification No. 61-01, Sheet No. 52, 7 March 1961, (HLM 10.05)]. FS Date: 6/9/2021

LS view: Closeup of pipe inlet at toe, underwater.

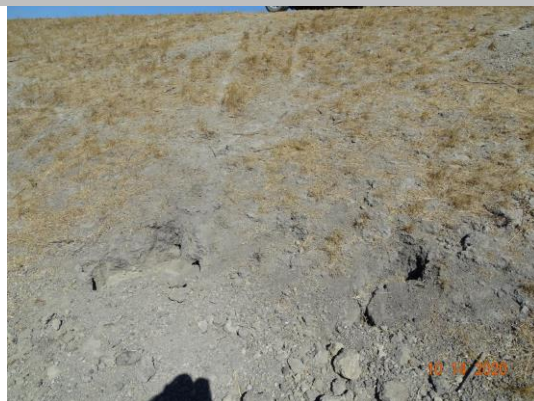
Photo 1 of 1 : SP_2022_NA0010_123_105_20220308_00013.jpg

LM Start	10.10	Rating **	M	Issue No.	105
LM End	10.10	Issue Type +	Ma	Location *	WS
Category	Earthen Levee			GPS Latitude/Longitude	
				Start	End
Item	Animal Control			37.194344 °	37.194344 °
				-120.679708 °	-120.679708 °
DWR ID	DWR_NA0010_05_f_2020_105				
Comment Code					
A3 : No rodents visible, but rodent burrows visible; need to backfill and compact or grout burrows.					
Inspector Comment

View of rodent activity in the landside slope. (Fall 2020)

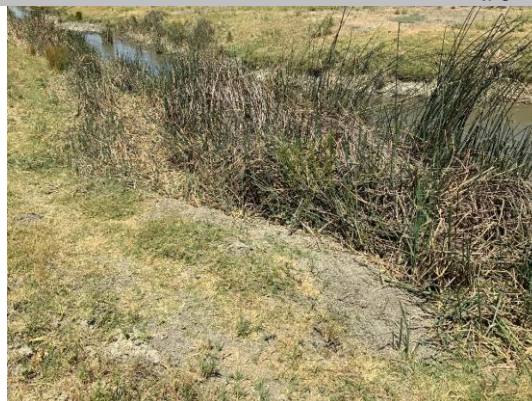
Comment Code					
Inspector Comment					
FS_ID:71011 DS_ID:19737 EP_NO: 18624 Repair Type: Non-Urgent Crossing Status: Indicator Found UCIP Comments: 06/9/2021 The record has been upgraded from No Action Needed to Non-Urgent. Only indicator found, pipe may be underwater. No pipe visible on LS, only riser. The UCIP inspection was completed with GEI staff, P. Espinoza. (H. Dunn ? GEI) FIELD_STRUCT_DESC: 36-inch rubber gasket reinforced concrete irrigation pipe (RGRCP) through the levee, 20.0 feet below the crown. Slide gate in a 72-inch concrete riser unit on the waterside (WS) shoulder. Concrete inlet structure off the landside (LS) toe. Joints secured in hoop steel and encased in concrete at levee toes. (36-inch RGRCP authorized under Permit No. 18624, 2011 - Wolfsen Land and Cattle Company). FS Date: 6/9/2021

LS view: Dense vegetation at the toe, pipe not visible.

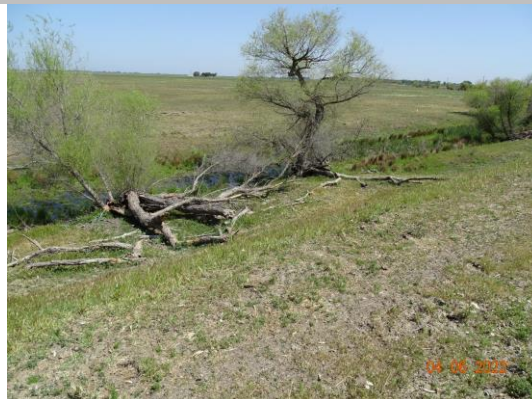
Photo 1 of 1 : SP_2022_NA0010_123_144_20220414_00368.jpg

LM Start	11.37	Rating **	M	Issue No.	144
LM End	11.37	Issue Type +	Ma	Location *	LS
Category	Earthen Levee			GPS Latitude/Longitude	
				Start	End
Item	Trim / Thin Trees			37.187792 °	37.187792 °
				-120.659454 °	-120.659454 °
DWR ID	DWR_NA0010_05_f_2018_144				
Comment Code					
T6 : Trees / Falling Tree.					
Inspector Comment					
Tree limbs on the levee slope should be trimmed to allow access.

View of tree limbs on levee slope. (Spring 2022)

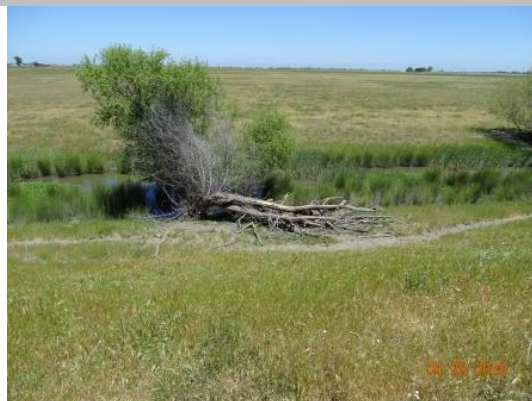
Photo 1 of 1 : SP_2022_NA0010_123_146_20220308_00040.jpg

LM Start	11.44	Rating **	M	Issue No.	146
LM End	11.44	Issue Type +	Ma	Location *	LS
Category	Earthen Levee			GPS Latitude/Longitude	
				Start	End
Item	Trim / Thin Trees			37.187021 °	37.187021 °
				-120.658564 °	-120.658564 °
DWR ID	DWR_NA0010_05_f_2018_146				
Comment Code					
T6 : Trees / Falling Tree.					
Inspector Comment					
Fallen tree limbs are located on the levee toe.

Tree limbs and trunk on levee toe. (Spring 2020)

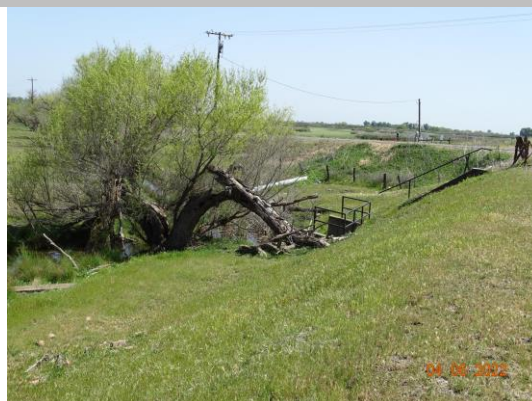
Photo 1 of 1 : SP_2022_NA0010_123_147_20220414_00369.jpg

LM Start	11.49	Rating **	U	Issue No.	147
LM End	11.49	Issue Type +	Ma	Location *	LS
Category	Earthen Levee			GPS Latitude/Longitude	
				Start	End
Item	Trim / Thin Trees			37.186482 °	37.186482 °
				-120.657935 °	-120.657935 °
DWR ID	DWR_NA0010_05_f_2021_147				
Comment Code					
T6 : Trees / Falling Tree.					
Inspector Comment					
Tree limbs are located on landside slope and toe.

Tree limbs on levee toe. (Spring 2022)

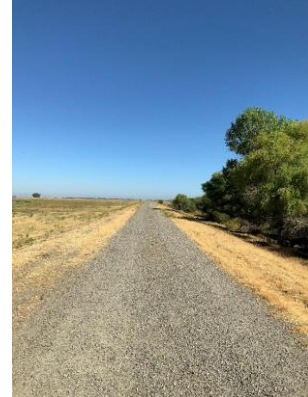
Comment Code						
Inspector Comment						
FS_ID:71012						
DS_ID:19768						
EP_NO: N/A						
Repair Type: Non-Urgent						
Crossing Status: Found						
UCIP Comments: 06/22/2021 The record has been upgraded from No Action Needed to Non-Urgent. Crossing appears to be in good condition. No permit was found authorizing this encroachment. CVFPB will need to review crossing to determine owner. The UCIP inspection was completed with GEI staff, H.Dunn. (P.Espinoza ? GEI)						
FIELD_STRUCT_DESC: [Deadman Drain] 1 of 2: 48-inch corrugated metal gravity drainage pipe (CMP) through the levee, 16.0 feet below the crown. Slide gate in a 60-inch CMP riser unit on the waterside (WS) slope. Concrete U-shaped headwall on each end. Stairs on the landside (LS) slope. [Additional Reference(s): DWR Levee Log, 2002, (HLM 11.45). USACE San Joaquin O&M Manual, Unit No. 601, Part No. 1, 1967, Amended in 1978, Revised 20 June 1985, (HLM 11.48). DWR As-Built Specification No. 61-01, Sheet No. 53, 7 March 1961, (HLM 11.48)].

View from levee crown.

LS view of slope from levee crown.

LS view: concrete headwall and inlet pipe visible on slope.

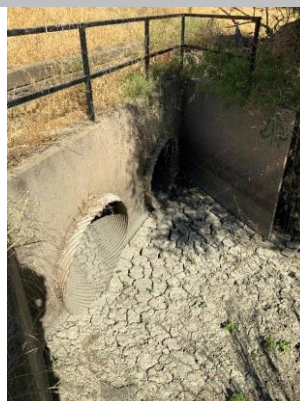
FS_ID:71013
DS_ID:19734
EP_NO: N/A
Repair Type: Non-Urgent
Crossing Status: Found
UCIP Comments: 06/22/2021 The record has been upgraded from No Action Needed to Non-Urgent. Crossing appears to be in good condition. No permit was found authorizing this encroachment. CVFPB will need to review crossing to determine owner. The UCIP inspection was completed with GEI staff, P. Espinoza. (H. Dunn ? GEI)
FIELD_STRUCT_DESC: [Deadman Drain] 2 of 2: 48-inch corrugated metal gravity drainage pipe (CMP) through the levee, 16.0 feet below the crown. Slide gate in a 60-inch CMP riser unit on the waterside (WS) slope. Concrete U-shaped headwall on each end. Stairs on the landside (LS) slope. [Additional Reference(s): DWR Levee Log, 2002, (HLM 11.45). USACE San Joaquin O&M Manual, Unit No. 601, Part No. 1, 1967, Amended in 1978, Revised 20 June 1985, (HLM 11.48). DWR As-Built Specification No. 61-01, Sheet No. 53, 7 March 1961, (HLM 11.48)].

Levee crown.

LS view: Toe from crown.

LS view: Closeup of inlet at toe.

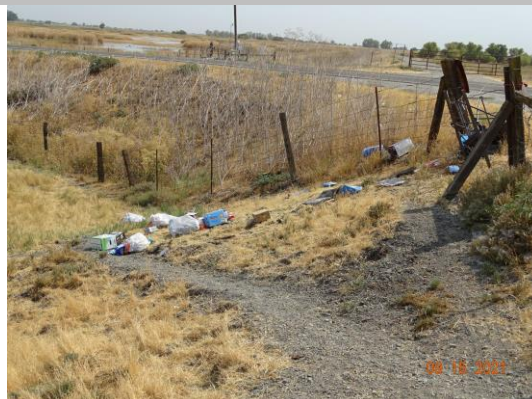
Photo 1 of 1 : SP_2022_NA0010_123_153_20220308_00046.jpg

LM Start	11.51	Rating **	M	Issue No.	153
LM End	11.51	Issue Type +	En	Location *	LS
Category	Earthen Levee			GPS Latitude/Longitude	
				Start	End
Item	Encroachments			37.186302 °	37.186302 °
				-120.657741 °	-120.657741 °
DWR ID	DWR_NA0010_05_f_2021_153				
Comment Code					
GA : Garbage					
Inspector Comment

View of garbage dumped on the landside slope and shoulder. (Fall 2021)
