**Flood Control Project Maintenance
Levee Inspections
LMA District Cover Sheet**

Lower San Joaquin Levee District

**Flood Control Project Maintenance
Levee Inspections
Unit Cover Sheet**

Levee Inspection Report By Mile - Spring 2022

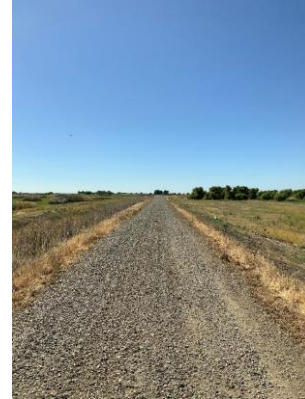
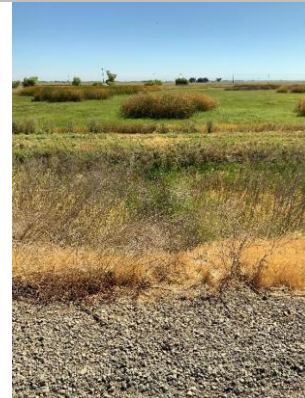
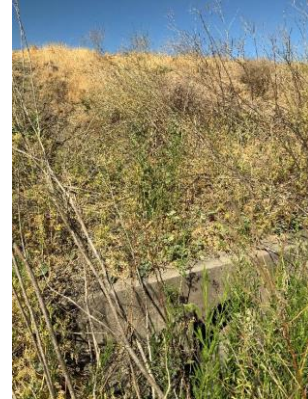
Comment Code					
Inspector Comment					
FS_ID:71015 DS_ID:19704 EP_NO: N/A Repair Type: Urgent Crossing Status: Found UCIP Comments: 06/22/2021 The record has been upgraded from No Action Needed to Urgent. DWR DMP internal inspection has found pipe integrity issues. LOF of crossing is greater than or equal to 5 and less than 6. Crossing will be monitored until funding becomes available to address the issues. Limited inspection of inlet pipe due to dense vegetation; removal recommended. No permit was found authorizing this encroachment. CVFPB will need to review crossing to determine owner. The UCIP inspection was completed with GEI staff, H.Dunn. (P.Espinoza ? GEI) FIELD_STRUCT_DESC: 24-inch corrugated metal gravity drainage pipe (CMP) through the levee, 11.8 feet below the crown. Flap gate on the waterside (WS) end. Concrete headwall on the landside (LS) end. Concrete saddle and apron on the WS end. [Additional Reference(s): DWR Levee Log, 2002, (HLM 11.60). USACE San Joaquin O&M Manual, Unit No. 601, Part No. 1, 1967, Amended in 1978, Revised 20 June 1985, (HLM 11.63). DWR As-Built Specification No. 61-01, Sheet No. 53, 7 March 1961, (HLM 11.63)]. FS Date: 6/22/2021

View of levee crown.

LS view: slope from crown.

LS view: concrete headwall and inlet pipe at toe. Slope visible in background.

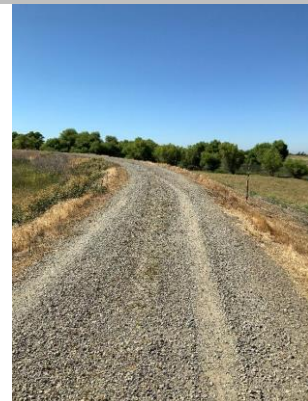
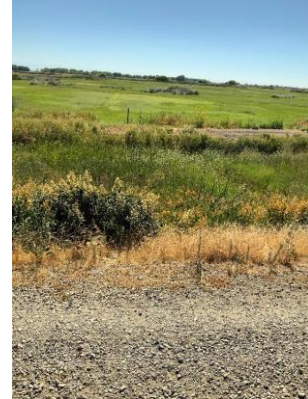
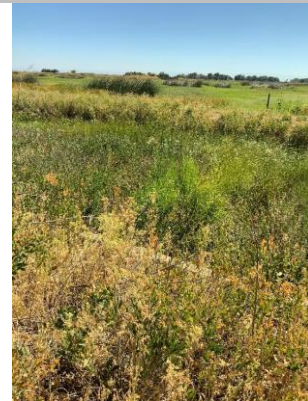
FS_ID:71016
DS_ID:19705
EP_NO: N/A
Repair Type: Urgent
Crossing Status: Found
UCIP Comments: 06/22/2021 The record has been upgraded from No Action Needed to Urgent. DWR DMP internal inspection has found pipe integrity issues. LOF of crossing is between 4.1 and 5. Crossing will be monitored until funding becomes available for rehabilitation. Limited inspection of LS due to dense vegetation; recommend removal. Erosion around concrete headwall on WS, at least 1 foot in depth. No permit was found authorizing this encroachment. CVFPB will need to review crossing to determine owner. The UCIP inspection was completed with GEI staff, H.Dunn. (P.Espinoza ? GEI)
FIELD_STRUCT_DESC: 24-inch corrugated metal gravity drainage pipe (CMP) through the levee, 12.5 feet below the crown. Flap gate on the waterside (WS) end. Concrete headwall on the landside (LS) end. Concrete saddle and apron on the WS end. Flashboard attachment on the LS end. [Additional Reference(s): DWR Levee Log, 2002, (HLM 11.98). USACE San Joaquin O&M Manual, Unit No. 601, Part No. 1, 1967, Amended in 1978, Revised 20 June 1985, (HLM 11.99). DWR As-Built Specification No. 61-01, Sheet No. 54, 7 March 1961, (HLM 11.99)].

View of levee crown.

LS view: slope from crown.

LS view: concrete headwall visible at toe.

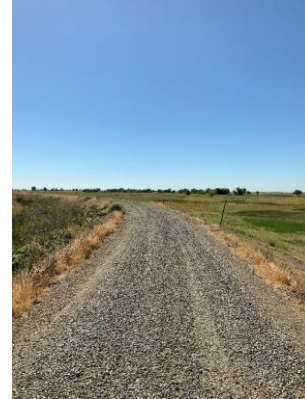
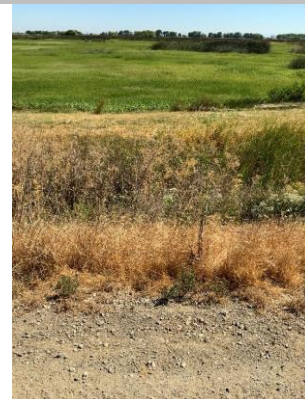
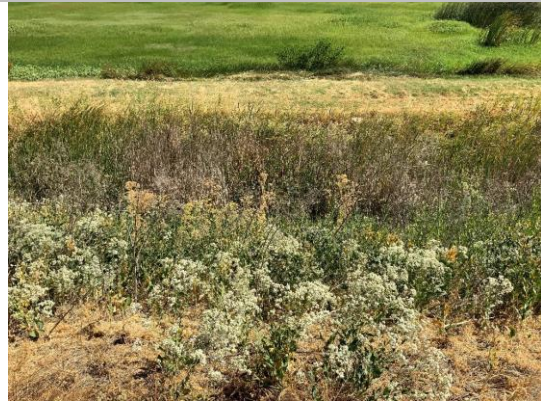
Comment Code						
Inspector Comment						
FS_ID:71017 DS_ID:19706 EP_NO: N/A Repair Type: Urgent Crossing Status: Found UCIP Comments: 06/22/2021 The record has been upgraded from No Action Needed to Urgent. DWR DMP internal inspection has found pipe integrity issues. LOF of crossing is between 5 and 6. Crossing will be monitored until funding becomes available to address the issues. Erosion around concrete headwall on WS, at least 1 foot in length. Limited inspection of LS due to vegetation and sediment; recommend removal. No permit was found authorizing this encroachment. CVFPB will need to review crossing to determine owner. The UCIP inspection was completed with GEI staff, H.Dunn. (P.Espinoza ? GEI) FIELD_STRUCT_DESC: 24-inch corrugated metal gravity drainage pipe (CMP) through the levee, 10.2 feet below the crown. Flap gate on the waterside (WS) end. Concrete headwall on the landside (LS) end. Concrete saddle and apron on the WS end. Flashboard attachment on the LS end. Pipe crosses levee at a 45-degree angle. [Additional Reference(s): DWR Levee Log, 2002, (HLM 12.38). USACE San Joaquin O&M Manual, Unit No. 601, Part No. 1, 1967, Amended in 1978, Revised 20 June 1985, (HLM 12.38). DWR As-Built Specification No. 61-01, Sheet No. 54, 7 March 1961, (HLM 12.38)]. FS Date: 6/22/2021

View of levee crown.

LS view of slope to toe from crown.

LS view: Slope from crown.

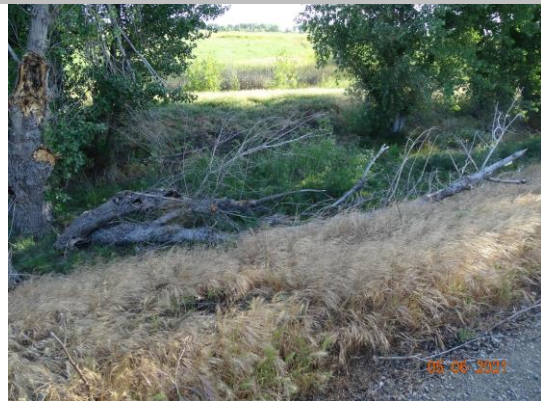
Photo 1 of 1 : SP_2022_NA0010_123_109_20220308_00014.jpg

LM Start	12.82	Rating **	U	Issue No.	109
LM End	12.82	Issue Type +	Ma	Location *	LS
Category	Earthen Levee			GPS Latitude/Longitude	
				Start	End
Item	Encroachments			37.175814 °	37.175814 °
				-120.642171 °	-120.642171 °
DWR ID	DWR_NA0010_05_s_2021_109				
Comment Code					
TR : Tree or limb					
Inspector Comment

Fallen tree limbs on the landside toe and slope. (Spring 2021)

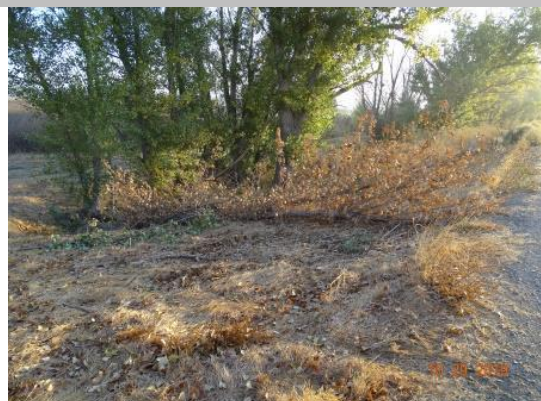
Photo 1 of 1 : SP_2022_NA0010_123_158_20220308_00049.jpg

LM Start	12.88	Rating **	M	Issue No.	158
LM End	12.88	Issue Type +	Ma	Location *	LS
Category	Earthen Levee			GPS Latitude/Longitude	
				Start	End
Item	Encroachments			37.175807 °	37.175807 °
				-120.641139 °	-120.641139 °
DWR ID	DWR_NA0010_05_f _ 2019_158				
Comment Code					
TR : Tree or limb					
Inspector Comment					
Tree limb on the landside slope should be removed.

View of downed tree limb on the landside slope. (Fall 2019)

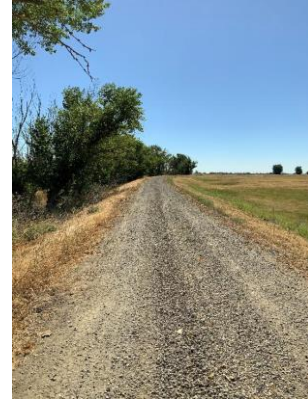
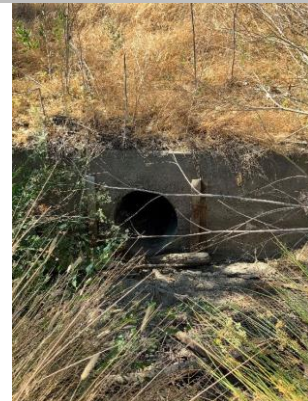
Comment Code						
Inspector Comment						
FS_ID:71018 DS_ID:19707 EP_NO: N/A Repair Type: Non-Urgent Crossing Status: Found UCIP Comments: 06/22/2021 The record remains Non-Urgent. DWR DMP internal inspection has found pipe integrity issues. LOF of crossing is between 4.1 and 5. Crossing will be monitored until funding becomes available for rehabilitation. Limited inspection of LS due to vegetation overgrowth; recommend removal. No permit was found authorizing this encroachment. CVFPB will need to review crossing to determine owner. The UCIP inspection was completed with GEI staff, H.Dunn. (P.Espinoza ? GEI) 04/22/2014 Sediment buildup in pipe visible from landward side--recommend contacting owner to clear pipe. (W. Wylie - DWR UCIP) FIELD_STRUCT_DESC: 24-inch corrugated metal gravity drainage pipe (CMP) through the levee, 10.2 feet below the crown. Concrete headwall on the landside (LS) end with flashboards. Concrete saddle and apron on the waterside (WS) end with a flap gate. Metal screen at the LS toe inlet. [Additional Reference(s): DWR Levee Log, 2002, (HLM 12.87). USACE San Joaquin O&M Manual, Unit No. 601, Part No. 1, 1967, Amended in 1978, Revised 20 June 1985, (HLM 12.87). DWR As-Built Specification No. 61-01, Sheet No. 54, 7 March 1961, (HLM 12.87)]. FS Date: 6/22/2021

View of levee crown.

LS view: concrete headwall and inlet pipe at toe.

LS view: concrete headwall and inlet pipe.

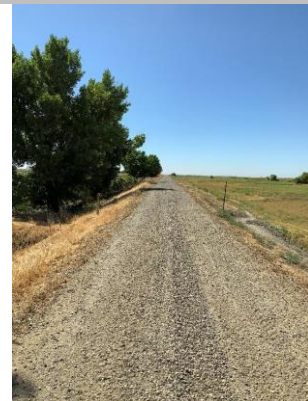
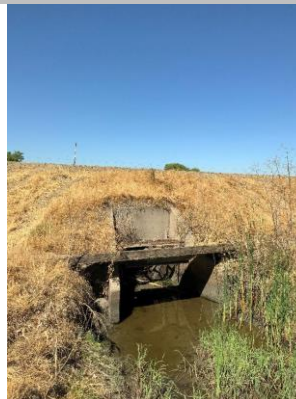
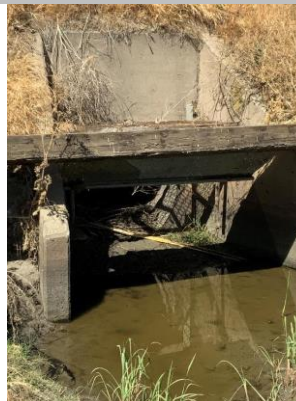
FS_ID:71019
DS_ID:19708
EP_NO: N/A
Repair Type: Non-Urgent
Crossing Status: Found
UCIP Comments: 06/22/2021 The record remains Non-Urgent. Limited inspection of LS due to water around the inlet at the time of survey. LS inlet has sediment buildup, recommend removal. No permit was found authorizing this encroachment. CVFPB will need to review crossing to determine owner. The UCIP inspection was completed with GEI staff, H.Dunn. (P.Espinoza ? GEI) 04/22/2014 Some erosion around headwall on the WS toe and there are animal burrows on both slopes. (W. Wylie - DWR UCIP)
FIELD_STRUCT_DESC: 48-inch corrugated metal gravity drainage pipe (CMP) through the levee, 10.0 feet below the crown. Flap gate on the waterside (WS) end. Flashboard attachment in a concrete U-shaped headwall on the landside (LS) end. Concrete U-shaped headwall on the WS end. [Additional Reference(s): DWR Levee Log, 2002, (HLM 13.40). USACE San Joaquin O&M Manual, Unit No. 601, Part No. 1, 1967, Amended in 1978, Revised 20 June 1985, (HLM 13.40)].

View of levee crown.

LS view from toe: concrete headwall and inlet pipe. Slope visible in background.

LS view from toe: closeup of concrete headwall and inlet.

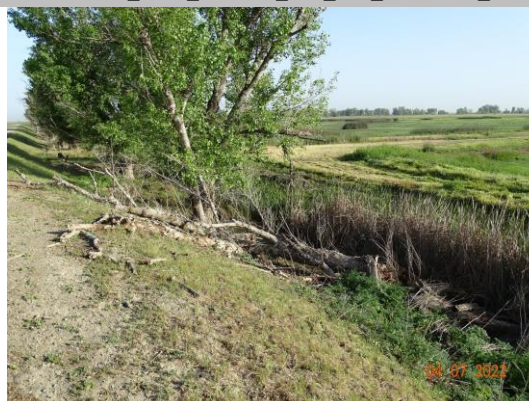
Photo 1 of 1 : SP_2022_NA0010_123_209_20220414_00372.jpg

LM Start	13.44	Rating **	U	Issue No.	209
LM End	13.44	Issue Type +	Ma	Location *	LS
Category	Earthen Levee			GPS Latitude/Longitude	
				Start	End
Item	Encroachments			37.171249 °	37.171249 °
				-120.633157 °	-120.633157 °
DWR ID	DWR_NA0010_05_s_2020_209				
Comment Code					
TR : Tree or limb					
Inspector Comment					
Dead tree should be removed before it can damage the levee.

Dead tree falling over on the landside toe. (Spring 2022)

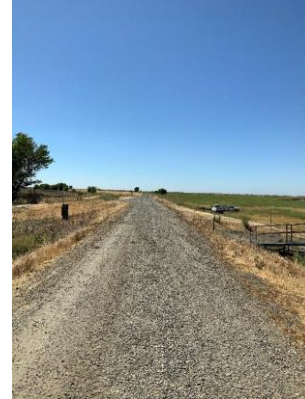
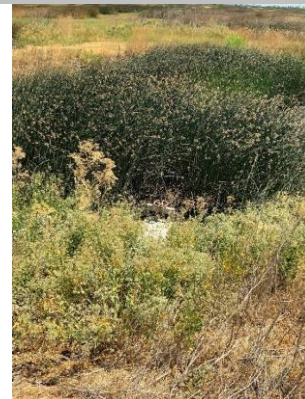
Comment Code					
Inspector Comment					
FS_ID:71020 DS_ID:19709 EP_NO: N/A Repair Type: Non-Urgent Crossing Status: Indicator Found UCIP Comments: 06/22/2021 The record remains Non-Urgent. Only LS slidegate visible, nothing seen on WS. DWR DMP geophysical study did not confirm presence of pipe through levee. Record will remain in UCIP's inspection records until future Levee Improvement Project can confirm no crossing was found through the levee. No permit was found authorizing this encroachment. CVFPB will need to review crossing to determine owner. The UCIP inspection was completed with GEI staff, H.Dunn. (P.Espinoza ? GEI)04/22/2014 Pipe not visible and may need to have silt removed from outlet on WS toe. (W. Wylie - DWR UCIP) FIELD_STRUCT_DESC: 24-inch corrugated metal gravity drainage pipe (CMP) through the levee, 10.0 feet below the crown. Flap gate on the waterside (WS) end. Slide gate on a concrete headwall at the landside (LS) toe. Concrete saddle and apron on the WS end. [Additional Reference(s): DWR Levee Log, 2002, (HLM 13.70). USACE San Joaquin O&M Manual, Unit No. 601, Part No. 1, 1967, Amended in 1978, Revised 20 June 1985, (recorded as HLM 14.72, should be 13.72)]. FS Date: 6/22/2021

View of levee crown.

LS view of slope to toe from crown.

WS view of slope from toe.

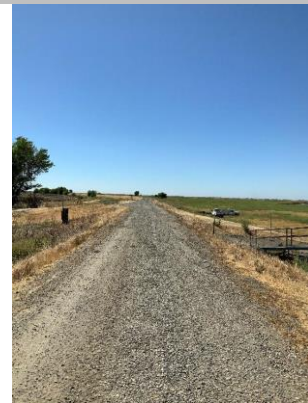
FS_ID:71021
 DS_ID:19566
 EP_NO: 17044
 Repair Type: Non-Urgent
 Crossing Status: Found
 UCIP Comments: 06/22/2021 The record has been upgraded from No Action Needed to Non-Urgent. Limited inspection of LS slidegate due to dense vegetation, recommend removal. The UCIP inspection was completed with GEI staff, P. Espinoza. (H. Dunn ? GEI)
 FIELD_STRUCT_DESC: 2 of 2: 20-inch coated steel drainage discharge pipe through the levee, 2.0 feet below the crown. Pump station off the landside (LS) toe. Siphon breaker on the apex of the pipe on the LS shoulder. Pipe extends past waterside (WS) slope to outlet in channel. Riprap around WS pipe outlet. (Two pump stations, 24-inch steel pipe, and 20-inch steel pipe authorized under Permit No. 17044, 1999 - Merced National Wildlife Service/Ducks Unlimited, Inc.).
 FS Date: 6/22/2021

Levee crown.

LS view: Meters on the toe.

LS view: Slope from toe.

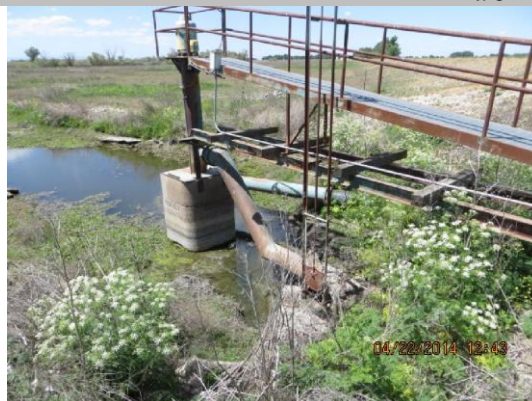
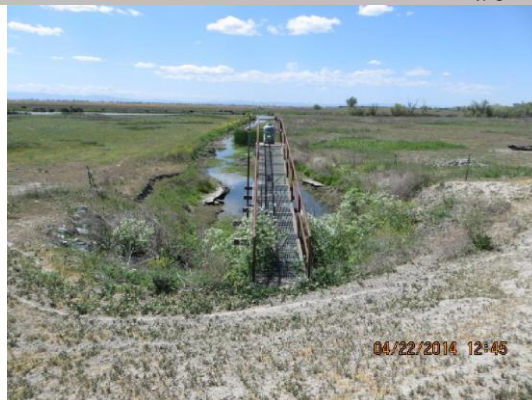
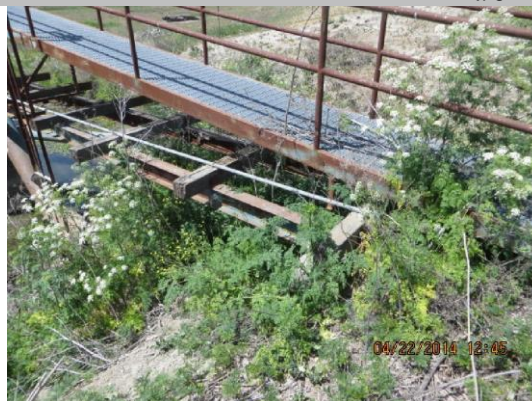
Comment Code					
Inspector Comment					
FS_ID:71022					
DS_ID:24869					
EP_NO: N/A					
Repair Type: Non-Urgent					
Crossing Status: Found					
UCIP Comments: 06/23/2021 The record has been upgraded from No Action Needed to Non-Urgent. Crossing appears in good condition. No permit was found authorizing this encroachment. CVFPB will need to review crossing to determine owner. The UCIP inspection was completed with GEI staff, P. Espinoza. (H. Dunn ? GEI)					
FIELD_STRUCT_DESC: 20-inch coated steel irrigation discharge pipe through the levee, at an unknown depth. Pump on a metal pile structure on the waterside (WS) toe with walkway. Pipe outlet not found at the landside (LS) toe. 1.5-inch galvanized iron electrical conduit at the same location. This crossing was field discovered.					
FS Date: 6/22/2021

Pump on pier on WS toe with metal walkway and 1.5-inch electrical conduit.

Pump on pier off WS shoulder.

1.5-inch electrical conduit at side of walkway on WS shoulder.

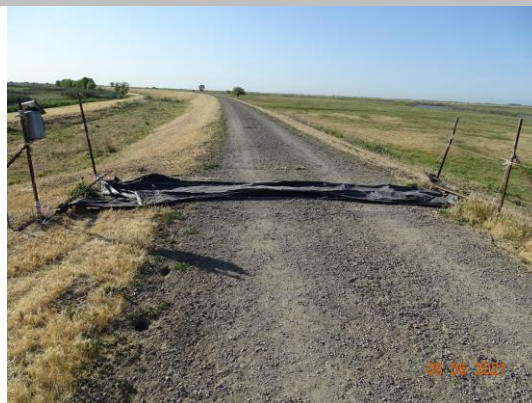
Photo 1 of 1 : SP_2022_NA0010_123_113_20220308_00017.jpg

The livestock fence across the crown has been removed, but the setup on the shoulders are still in place.

View of temporary fence installed by landowner. (Spring 2021)

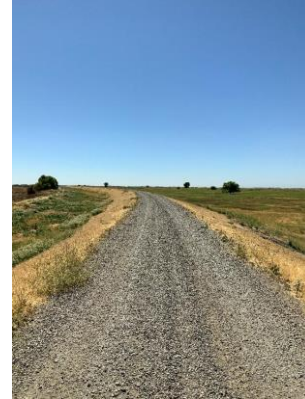
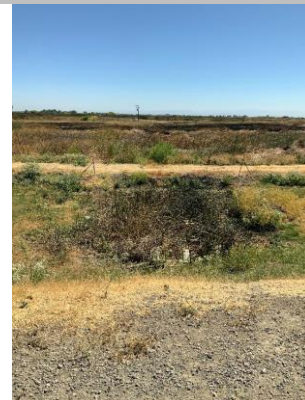
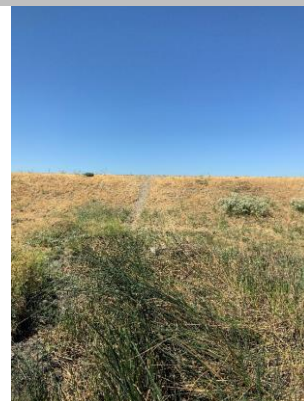
Comment Code						
Inspector Comment						
FS_ID:71023 DS_ID:19710 EP_NO: N/A Repair Type: Urgent Crossing Status: Found UCIP Comments: 06/22/2021 The record has been upgraded from No Action Needed to Urgent. Subsidence along the WS slope that is at least 1 foot in length. Limited inspection of LS due to vegetation; recommend removal. No permit was found authorizing this encroachment. CVFPB will need to review crossing to determine owner. The UCIP inspection was completed with GEI staff, H.Dunn. (P.Espinoza ? GEI) FIELD_STRUCT_DESC: 24-inch corrugated metal gravity drainage pipe (CMP) through the levee, 12.4 feet below the crown. Flap gate on the waterside (WS) end. Concrete headwall on each end. [Additional Reference(s): DWR Levee Log, 2002, (HLM 13.84). USACE San Joaquin O&M Manual, Unit No. 601, Part No. 1, 1967, Amended in 1978, Revised 20 June 1985, (HLM 13.83). DWR As-Built Specification No. 61-01, Sheet No. 55, 7 March 1961, (HLM 13.83)]. FS Date: 6/22/2021

View of levee crown.

LS view: slope to toe from crown.

LS view of slope from toe.

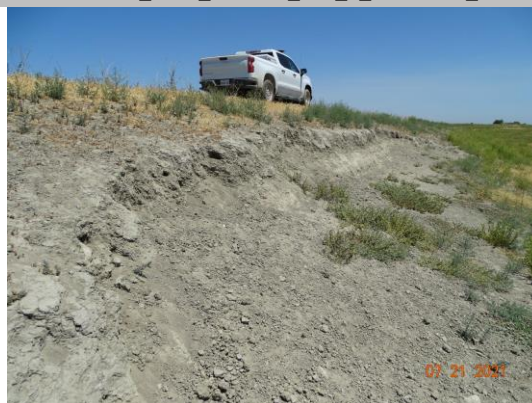
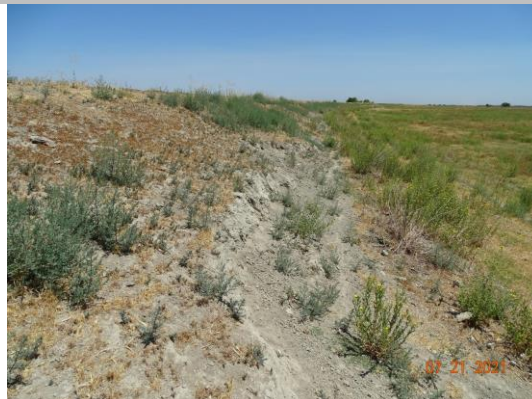
LM Start	14.39	Rating **	M	Issue No.	3
LM End	14.45	Issue Type +	Ma	Location *	WS
Category	Supplemental			GPS Latitude/Longitude	
				Start	End
Item	DWR Erosion Survey			37.162949 °	37.162949 °
				-120.619138 °	-120.619138 °
DWR ID	NA0010U05RM12.22				
Comment Code					
Inspector Comment					
Site ID: NA0010U05RM12.22 07/21/2021: This site was discovered during the DWR Spring 2021 Levee Inspections. There is a series of erosion pockets along the lower levee slope and toe, ranging from 3 ft in length to 15 ft and 2 ft to 7 ft in scarp height. There are lots of rodent holes on the entire levee slope.

7/21/2021: View of an erosion pocket and large animal hole looking upstream.

7/21/2021: View of a large erosion pocket.

7/21/2021: Close-up view of the erosion near the upstream end.

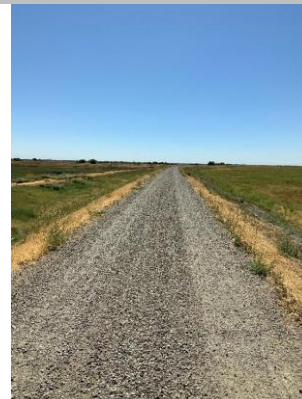
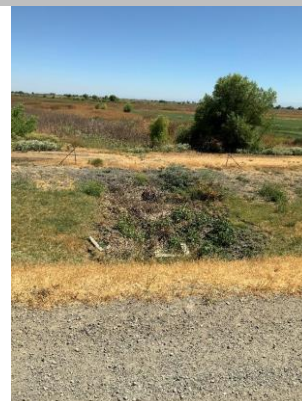
Comment Code					
Inspector Comment					
FS_ID:71024 DS_ID:19711 EP_NO: N/A Repair Type: Non-Urgent Crossing Status: Found UCIP Comments: 06/22/2021 The record has been upgraded from No Action Needed to Non-Urgent. Dense vegetation on LS; recommend removal. No permit was found authorizing this encroachment. CVFPB will need to review crossing to determine owner. The UCIP inspection was completed with GEI staff, H.Dunn. (P.Espinoza ? GEI) FIELD_STRUCT_DESC: 24-inch corrugated metal gravity drainage pipe (CMP) through the levee, 12.5 feet below the crown. Flap gate on the waterside (WS) end. Concrete headwall on each end. Concrete weir inlet structure on the landside (LS) toe. [Additional Reference(s): DWR Levee Log, 2002, (HLM 14.44). USACE San Joaquin O&M Manual, Unit No. 601, Part No. 1, 1967, Amended in 1978, Revised 20 June 1985, (HLM 14.44)] FS Date: 6/22/2021

View from levee crown.

LS view of slope to toe from crown.

LS view of slope from toe: concrete headwall visible in background.

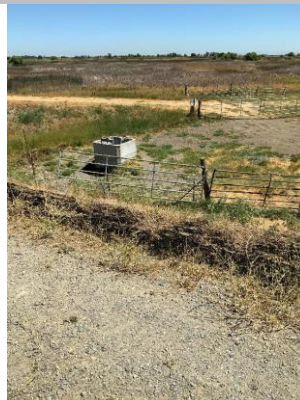
Comment Code					
Inspector Comment					
FS_ID:71025 DS_ID:19712 EP_NO: N/A Repair Type: Non-Urgent Crossing Status: Found UCIP Comments: 06/22/2021 The record remains Non-Urgent. Limited inspection on LS due to barbed wire and access issues. Build up of sediment at WS outlet pipe and LS inlet pipe; recommend removal. Some erosion along the WS slope, less than 1 foot. No permit was found authorizing this encroachment. CVFPB will need to review crossing to determine owner. The UCIP inspection was completed with GEI staff, H.Dunn. (P.Espinoza ? GEI) 04/23/2014 Minor erosion at headwall on WS toe. (W. Wylie - DWR UCIP) FIELD_STRUCT_DESC: 36-inch corrugated metal gravity drainage pipe (CMP) through the levee, 11.9 feet below the crown. Flap gate on the waterside (WS) end. Concrete headwall on each end. [Additional Reference(s): DWR Levee Log, 2002, (HLM 15.08). USACE San Joaquin O&M Manual, Unit No. 601, Part No. 1, 1967, Amended in 1978, Revised 20 June 1985, (HLM 15.09)]. FS Date: 6/22/2021

View from levee crown.

LS view of slope to toe from crown. Headwall visible in background.

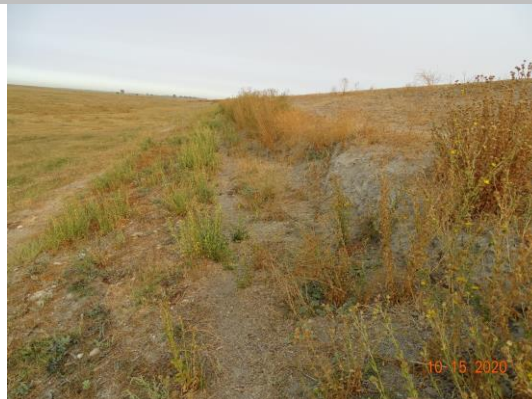
Photo 1 of 1 : SP_2022_NA0010_123_110_20220308_00015.jpg

LM Start	15.21	Rating **	M	Issue No.	110
LM End	15.26	Issue Type +	Ma	Location *	WS
Category	Earthen Levee			GPS Latitude/Longitude	
				Start	End
Item	Erosion / Bank Caving			37.155782 °	37.155337 °
				-120.608075 °	-120.607449 °
DWR ID	DWR_NA0010_05_f_2020_110				
Comment Code					
E1 : Note and monitor erosion site.					
Inspector Comment

Erosion along the waterside slope. (Fall 2020)

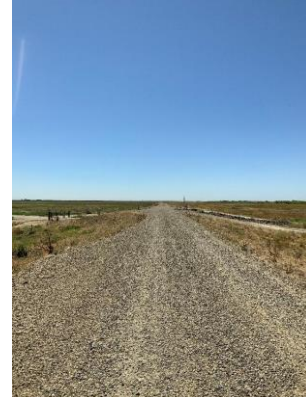
Photo 1 of 3 : UCIP_SP_2022_71026_104037.jpg

Comment Code						
Inspector Comment						
FS_ID:71026 DS_ID:19713 EP_NO: N/A Repair Type: Non-Urgent Crossing Status: Found UCIP Comments: 06/22/2021 The record remains Non-Urgent. Crossing appears to be in good condition. No permit was found authorizing this encroachment. CVFPB will need to review crossing to determine owner. The UCIP inspection was completed with GEI staff, H.Dunn. (P.Espinoza ? GEI) 04/23/2014 Sediment buildup in pipe visible from landward side--recommend contacting owner to clear pipe. (W. Wylie - DWR UCIP) FIELD_STRUCT_DESC: 24-inch corrugated metal gravity drainage pipe (CMP) through the levee, 11.0 feet below the crown. Flap gate on the waterside (WS) end. Concrete headwall on each end. [Additional Reference(s): DWR Levee Log, 2002, (HLM 15.74). USACE San Joaquin O&M Manual, Unit No. 601, Part No. 1, 1967, Amended in 1978, Revised 20 June 1985, (HLM 15.74)]. FS Date: 6/22/2021

View from levee crown.

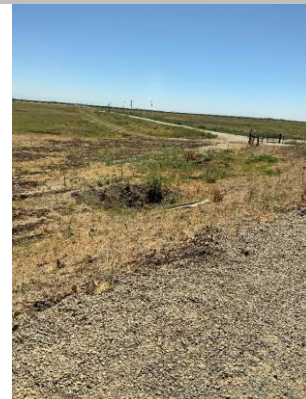
Photo 2 of 3 : UCIP_SP_2022_71026_104039.jpg

LS view of slope to toe from crown.

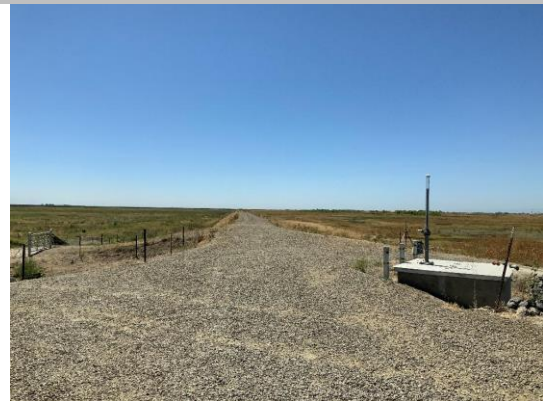
Photo 1 of 3 : UCIP_SP_2022_71027_104052.jpg

FS_ID:71027
DS_ID:19714
EP_NO: N/A
Repair Type: Non-Urgent
Crossing Status: Found
UCIP Comments: 06/22/2021 The record has been upgraded from No Action Needed to Non-Urgent. Limited inspection of LS and WS due to water present at the time of survey. No permit was found authorizing this encroachment. CVFPB will need to review crossing to determine owner. The UCIP inspection was completed with GEI staff, H.Dunn. (P.Espinoza ? GEI)
FIELD_STRUCT_DESC: 36-inch corrugated metal gravity irrigation pipe (CMP) through the levee, 9.8 feet below the crown. Slide gate in a 48-inch CMP riser unit on the waterside (WS) slope. Concrete headwall on each end. [Additional Reference(s): DWR Levee Log, 2002, (HLM 15.76). USACE San Joaquin O&M Manual, Unit No. 601, Part No. 1, 1967, Amended in 1978, Revised 20 June 1985, (HLM 15.77)].
FS Date: 6/22/2021

View from levee crown.

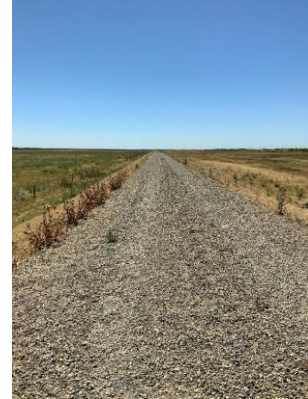
Photo 1 of 3 : UCIP_SP_2022_71028_104057.jpg

Comment Code						
Inspector Comment						
FS_ID:71028 DS_ID:19715 EP_NO: N/A Repair Type: Non-Urgent Crossing Status: Found UCIP Comments: 06/22/2021 The record remains Non-Urgent. Crossing appears to be in good condition. No permit was found authorizing this encroachment. CVFPB will need to review crossing to determine owner. The UCIP inspection was completed with GEI staff, H.Dunn. (P.Espinoza ? GEI) 04/23/2014 Excess vegetation at inlet on LS toe should be cleared. (W. Wylie - DWR UCIP) FIELD_STRUCT_DESC: 24-inch corrugated metal gravity drainage pipe (CMP) through the levee, 12.0 feet below the crown. Flap gate on the waterside (WS) end. Concrete headwall on the landside (LS) end. Concrete saddle and apron on the WS end. [Additional Reference(s): DWR Levee Log, 2002, (HLM 15.79). USACE San Joaquin O&M Manual, Unit No. 601, Part No. 1, 1967, Amended in 1978, Revised 20 June 1985, (HLM 15.80)]. FS Date: 6/22/2021

View from levee crown.

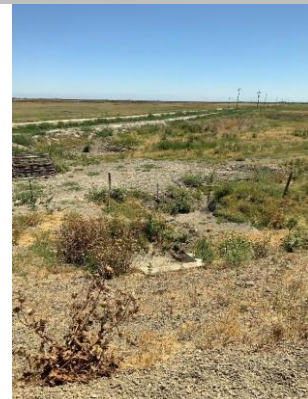
Photo 2 of 3 : UCIP_SP_2022_71028_104056.jpg

LS view of slope to toe from crown. Concrete headwall visible at toe.

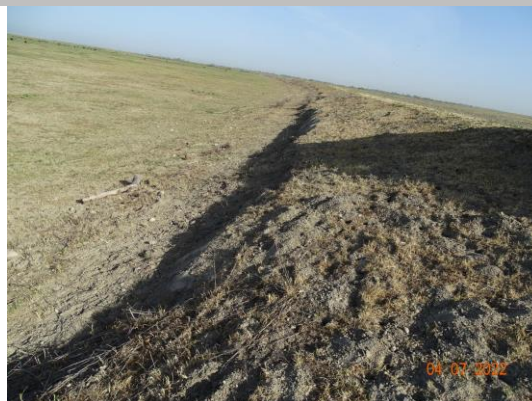
Photo 1 of 1 : SP_2022_NA0010_123_173_20220414_00374.jpg

Looking downstream along the waterside slope at erosion from livestock activity. (Spring 2022)

LM Start	16.34	Rating **	M	Issue No.	173
LM End	16.34	Issue Type +	Ma	Location *	WS
Category	Earthen Levee			GPS Latitude/Longitude	
				Start	End
Item	Erosion / Livestock			37.143141 °	37.143141 °
				-120.595183 °	-120.595183 °
DWR ID	DWR_NA0010_05_s_2022_173				
Comment Code					
E4 : Repair the levee slope damaged by livestock and prevent large animal access.					
Inspector Comment

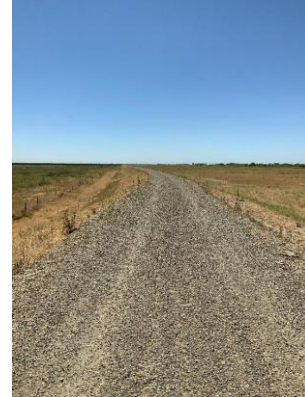
Photo 1 of 3 : UCIP_SP_2022_71029_104063.jpg

Comment Code					
Inspector Comment					
FS_ID:71029 DS_ID:19716 EP_NO: N/A Repair Type: Non-Urgent Crossing Status: Found UCIP Comments: 06/22/2021 The record remains Non-Urgent. Crossing appears to be in good condition. No permit was found authorizing this encroachment. CVFPB will need to review crossing to determine owner. The UCIP inspection was completed with GEI staff, H.Dunn. (P.Espinoza ? GEI) 04/23/2014 Pipe heavily silted on LS toe. (W. Wylie - DWR UCIP) FIELD_STRUCT_DESC: 24-inch corrugated metal gravity drainage pipe (CMP) through the levee, 10.5 feet below the crown. Flap gate on the waterside (WS) end. Concrete headwall on each end. [Additional Reference(s): DWR Levee Log, 2002, (HLM 16.66). USACE San Joaquin O&M Manual, Unit No. 601, Part No. 1, 1967, Amended in 1978, Revised 20 June 1985, (HLM 16.67). DWR As-Built Specification No. 61-01, Sheet No. 57, 7 March 1961, (HLM 16.67)]. FS Date: 6/22/2021

View from levee crown.

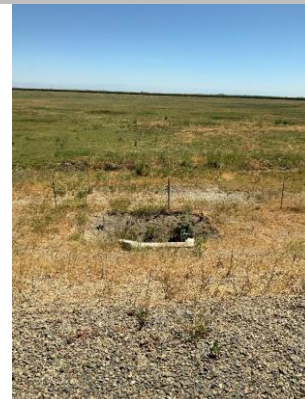
Photo 2 of 3 : UCIP_SP_2022_71029_104064.jpg

LS view of slope to toe from crown.

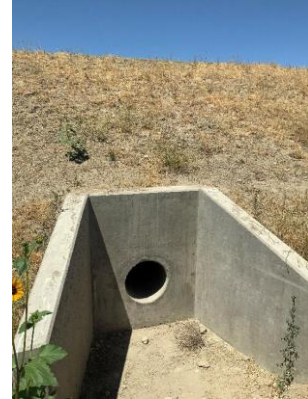
Photo 3 of 3 : UCIP_SP_2022_71029_104068.jpg

LS view from toe: concrete headwall and inlet. Slope visible in background.

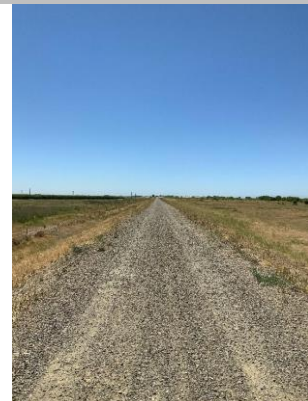
Photo 1 of 3 : UCIP_SP_2022_71030_104070.jpg

FS_ID:71030
DS_ID:19717
EP_NO: N/A
Repair Type: Non-Urgent
Crossing Status: Found
UCIP Comments: 06/22/2021 The record remains Non-Urgent. Crossing appears to be in good condition. No permit was found authorizing this encroachment. CVFPB will need to review crossing to determine owner. The UCIP inspection was completed with GEI staff, H.Dunn. (P.Espinoza ? GEI) 04/23/2014 Sediment buildup in pipe visible from landward side--recommend contacting owner to clear pipe. (W. Wylie - DWR UCIP)
FIELD_STRUCT_DESC: 24-inch corrugated metal gravity drainage pipe (CMP) through the levee, 12.0 feet below the crown. Flap gate on the waterside (WS) end. Concrete headwall on each end. [Additional Reference(s): DWR Levee Log, 2002, (HLM 17.21). USACE San Joaquin O&M Manual, Unit No. 601, Part No. 1, 1967, Amended in 1978, Revised 20 June 1985, (HLM 17.20)].
FS Date: 6/22/2021

View from levee crown.

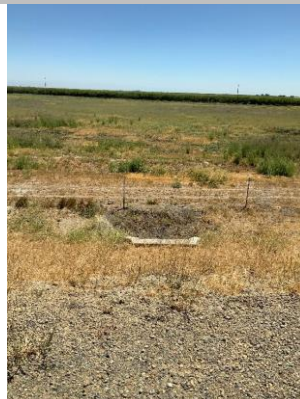
Photo 2 of 3 : UCIP_SP_2022_71030_104071.jpg

LS view of slope to toe from crown.

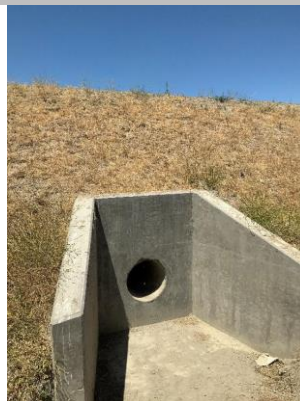
Photo 3 of 3 : UCIP_SP_2022_71030_104075.jpg

LS view at toe: concrete headwall and inlet. Slope visible in background.

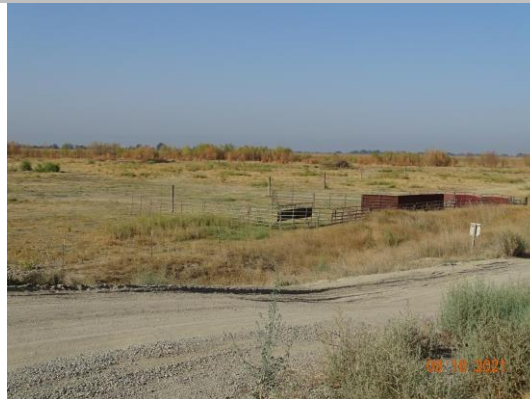
Photo 1 of 1 : SP_2022_NA0010_123_155_20220308_00048.jpg

LM Start	17.54	Rating **	M	Issue No.	155
LM End	17.54	Issue Type +	En	Location *	WS
Category	Rivers, Channels & Designated Floodways			GPS Latitude/Longitude	
				Start	End
Item	Encroachments			37.127871 °	37.127871 °
				-120.585273 °	-120.585273 °
DWR ID	DWR_NA0010_05_f_2021_155				
Comment Code					
Inspector Comment					
Livestock pen in the channel.

Landowner has put up a livestock pen within the bypass channel. (Fall 2021)

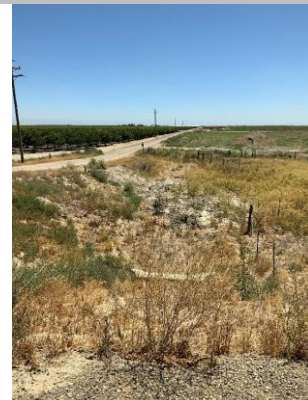
Photo 2 of 3 : UCIP_SP_2022_71031_104078.jpg

LS view of slope to toe from crown. Concrete headwall visible at toe.

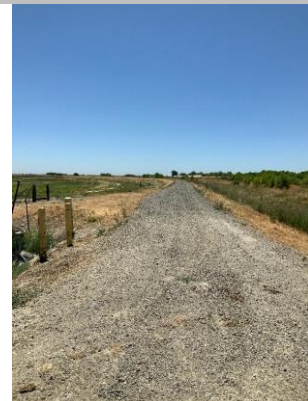
Photo 1 of 3 : UCIP_SP_2022_71032_104094.jpg

FS_ID:71032
 DS_ID:19744
 EP_NO: 3040
 Repair Type: Non-Urgent
 Crossing Status: Found
 UCIP Comments: 06/22/2021 The record has been upgraded from No Action Needed to Non-Urgent. Limited inspection of LS outlet due to water flowing through the pipe during time of inspection. Limited inspection of WS inlet due to large herd of cows surrounding inlet. The UCIP inspection was completed with GEI staff, P. Espinoza. (H. Dunn ? GEI)
 FIELD_STRUCT_DESC: [Newhall Siphon Crossing] 48-inch corrugated metal irrigation siphon pipe (CMP) through the levee, 6.0 feet below the crown. Slide gate in a 60-inch CMP riser unit on the landside (LS) slope. Concrete U-shaped headwall on the LS end. Siphon under channel. 24-inch CMP cleanout at the center of the channel. Metal plate cover. (Two reinforced concrete [RC] siphons across the Eastside Bypass authorized under Permit No. 3040, 1959 - Newhall Land and Farming Company).

Levee crown.

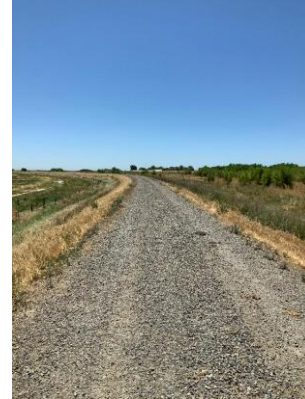
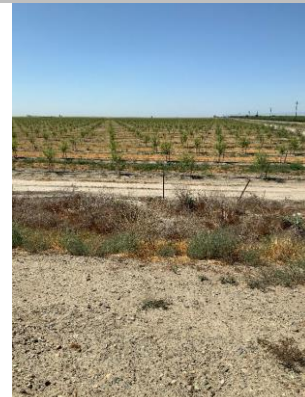
Comment Code					
Inspector Comment					
FS_ID:71033 DS_ID:19745 EP_NO: N/A Repair Type: Non-Urgent Crossing Status: Found UCIP Comments: 06/22/2021 The record remains Non-Urgent. Limited inspection of LS pipe inlet due to dense vegetation, recommend removal. No permit was found authorizing this encroachment. CVFPB will need to review crossing to determine owner. The UCIP inspection was completed with GEI staff, P. Espinoza. (H. Dunn ? GEI) 04/23/2014 Animal burrows in levee on both slopes. (W. Wylie - DWR UCIP) FIELD_STRUCT_DESC: 24-inch corrugated metal gravity drainage pipe (CMP) through the levee, 12.4 feet below the crown. Flap gate on the waterside (WS) end. Concrete headwall on each end. [Additional Reference(s): DWR Levee Log, 2002, (HLM 18.07). USACE San Joaquin O&M Manual, Unit No. 601, Part No. 1, 1967, Amended in 1978, Revised 20 June 1985, (HLM 18.07). DWR As-Built Specification No. 61-01, Sheet No. 58, 7 March 1961, (HLM 18.07)]. FS Date: 6/22/2021

Levee crown.

LS view: Toe from crown.

LS view: Slope from toe.

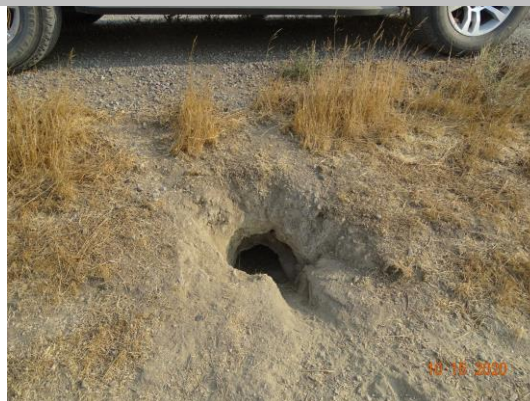
Photo 1 of 1 : SP_2022_NA0010_123_114_20220308_00018.jpg

LM Start	18.50	Rating **	U	Issue No.	114
LM End	18.50	Issue Type +	Ma	Location *	WS
Category	Earthen Levee			GPS Latitude/Longitude	
				Start	End
Item	Animal Control			37.115960 °	37.115960 °
				-120.577170 °	-120.577170 °
DWR ID	DWR_NA0010_05_f_2020_114				
Comment Code					
A3 : No rodents visible, but rodent burrows visible; need to backfill and compact or grout burrows.					
Inspector Comment					
Burrow appears to connect to hole in landside shoulder.

View of rodent burrow in the waterside shoulder. (Fall 2020)

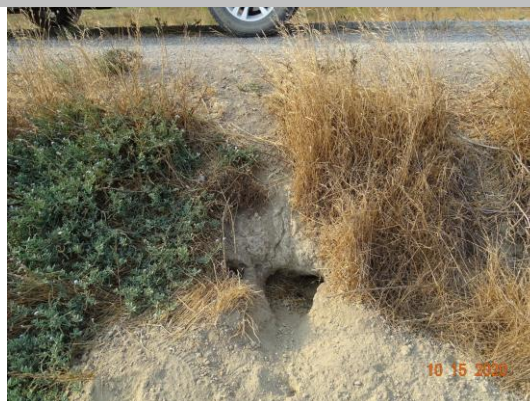
Photo 1 of 1 : SP_2022_NA0010_123_118_20220308_00020.jpg

LM Start	18.50	Rating **	U	Issue No.	118
LM End	18.50	Issue Type +	Ma	Location *	LS
Category	Earthen Levee			GPS Latitude/Longitude	
				Start	End
Item	Animal Control			37.115960 °	37.115960 °
				-120.577170 °	-120.577170 °
DWR ID	DWR_NA0010_05_f_2020_118				
Comment Code					
A3 : No rodents visible, but rodent burrows visible; need to backfill and compact or grout burrows.					
Inspector Comment					
Burrow appears to connect to hole in waterside shoulder.

Large rodent hole in the landside shoulder. (Fall 2020)

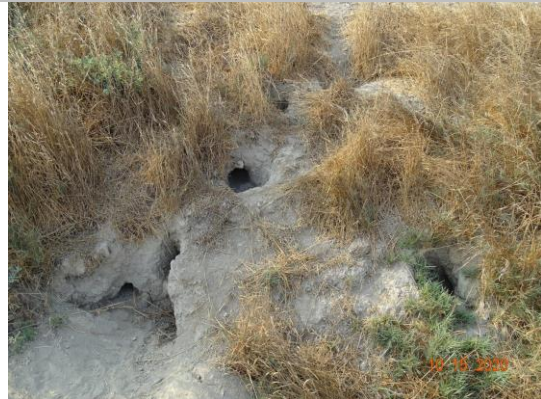
Photo 1 of 1 : SP_2022_NA0010_123_126_20220308_00026.jpg

LM Start	18.62	Rating **	U	Issue No.	126
LM End	18.62	Issue Type +	Ma	Location *	LS
Category	Earthen Levee			GPS Latitude/Longitude	
				Start	End
Item	Animal Control			37.115481 °	37.115481 °
				-120.575126 °	-120.575126 °
DWR ID	DWR_NA0010_05_f_2020_126				
Comment Code					
A3 : No rodents visible, but rodent burrows visible; need to backfill and compact or grout burrows.					
Inspector Comment

Several large rodent holes observed at this location. (Fall 2020)

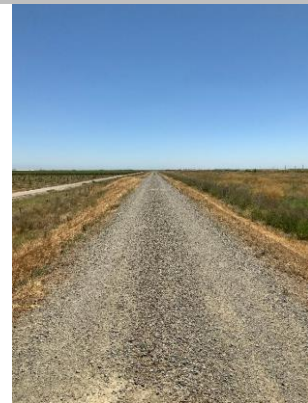
Comment Code						
Inspector Comment						
FS_ID:71034 DS_ID:19746 EP_NO: N/A Repair Type: Non-Urgent Crossing Status: Found UCIP Comments: 06/22/2021 The record remains Non-Urgent. Crossing appears to be in good condition. No permit was found authorizing this encroachment. CVFPB will need to review crossing to determine owner. The UCIP inspection was completed with GEI staff, P. Espinoza. (H. Dunn ? GEI) 04/23/2014 Dense vegetation limits the inspector's visibility to identify signs of pipe failure (leaks) along the landward slope. Recommend removing vegetation along pipe alignment to conduct proper inspection of structure. (W. Wylie - DWR UCIP) FIELD_STRUCT_DESC: 24-inch corrugated metal gravity drainage pipe (CMP) through the levee, 10.0 feet below the crown. Flap gate on the waterside (WS) end. Concrete headwall on the landside (LS) end. Concrete U-shaped headwall on the WS end. [Additional Reference(s): DWR Levee Log, 2002, (HLM 18.68). USACE San Joaquin O&M Manual, Unit No. 601, Part No. 1, 1967, Amended in 1978, Revised 20 June 1985, (HLM 18.68). DWR As-Built Specification No. 64-01, Sheet No. 3, 6 November 1963, (HLM 18.68)]. FS Date: 6/22/2021

Levee crown.

LS view: Toe from crown.

LS view: Slope and headwall from toe.

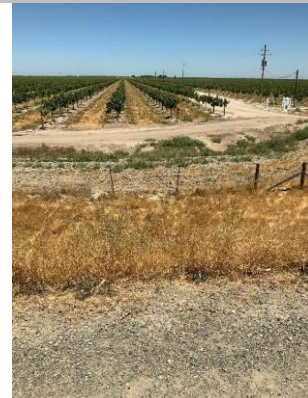
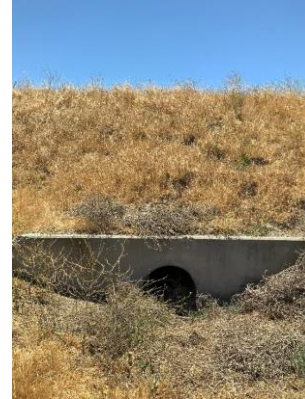
Comment Code						
Inspector Comment						
FS_ID:71035 DS_ID:19747 EP_NO: N/A Repair Type: Non-Urgent Crossing Status: Found UCIP Comments: 06/22/2021 The record remains Non-Urgent. Limited inspection due to LS inlet being covered by dense tumbleweeds, recommend removal. No permit was found authorizing this encroachment. CVFPB will need to review crossing to determine owner. The UCIP inspection was completed with GEI staff, P. Espinoza. (H. Dunn ? GEI) 04/23/2014 Sediment buildup in pipe visible from landward side--recommend contacting owner to clear pipe. (W. Wylie - DWR UCIP) FIELD_STRUCT_DESC: 24-inch corrugated metal gravity drainage pipe (CMP) through the levee, 10.0 feet below the crown. Flap gate on the waterside (WS) end. Concrete headwall on the landside (LS) end. Concrete U-shaped headwall on the WS end. [Additional Reference(s): DWR Levee Log, 2002, (HLM 19.13). USACE San Joaquin O&M Manual, Unit No. 601, Part No. 1, 1967, Amended in 1978, Revised 20 June 1985, (HLM 19.11). DWR As-Built Specification No. 64-01, Sheet No. 3, 6 November 1963, (HLM 19.11)]. FS Date: 6/22/2021

Levee crown.

LS view: Toe from crown.

LS view: Slope and headwall at toe.

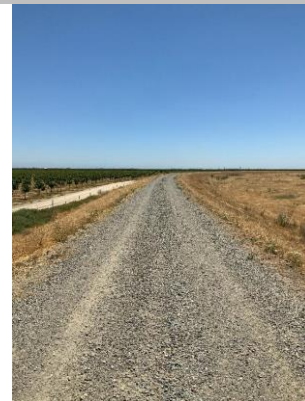
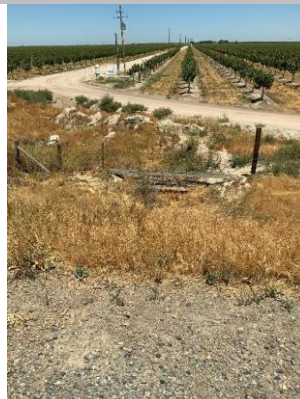
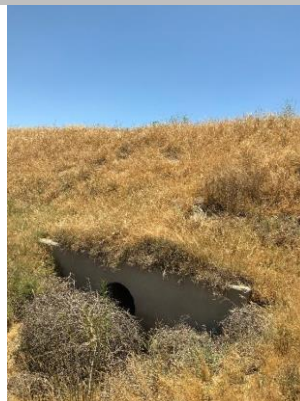
FS_ID:71036
 DS_ID:19776
 EP_NO: N/A
 Repair Type: Non-Urgent
 Crossing Status: Found
 UCIP Comments: 06/22/2021 The record has been upgraded from No Action Needed to Non-Urgent. Some tumbleweed buildup around LS inlet, recommend removal. No permit was found authorizing this encroachment. CVFPB will need to review crossing to determine owner. The UCIP inspection was completed with GEI staff, P. Espinoza. (H. Dunn ? GEI)
 FIELD_STRUCT_DESC: 24-inch corrugated metal gravity drainage pipe (CMP) through the levee, 10.3 feet below the crown. Flap gate on the waterside (WS) end. Concrete headwall on the landside (LS) end. Concrete U-shaped headwall on the WS end. [Additional Reference(s): DWR Levee Log, 2002, (HLM 19.15). USACE San Joaquin O&M Manual, Unit No. 601, Part No. 1, 1967, Amended in 1978, Revised 20 June 1985, (HLM 19.15). DWR As-Built Specification No. 64-01, Sheet No. 3, 6 November 1963, (HLM 19.15)].

Levee crown.

LS view: Toe from crown.

LS view: Headwall and slope from toe.

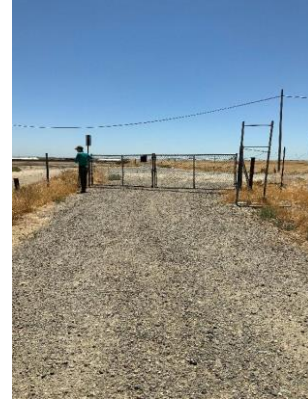
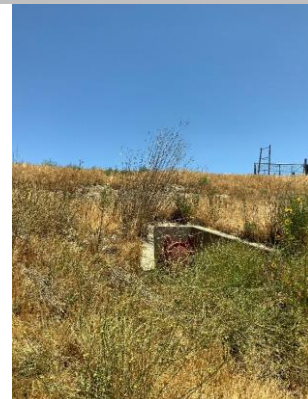
Comment Code						
Inspector Comment						
FS_ID:71037						
DS_ID:19777						
EP_NO: N/A						
Repair Type: Urgent						
Crossing Status: Found						
UCIP Comments: 06/22/2021 The record has been upgraded from Non-Urgent to Urgent. DWR DMP internal inspection has found pipe integrity issues. LOF of crossing is greater than or equal to 5 and less than 6. Crossing will be monitored until funding becomes available to address the issues. Limited inspection of LS inlet due to vegetation, recommend removal. No permit was found authorizing this encroachment. CVFPB will need to review crossing to determine owner. The UCIP inspection was completed with GEI staff, P. Espinoza. (H. Dunn ? GEI)04/23/2014 Sediment buildup in pipe visible from landward side-- recommend contacting owner to clear pipe. (W. Wylie - DWR UCIP) FIELD_STRUCT_DESC: 24-inch corrugated metal gravity drainage pipe (CMP) through the levee, 9.0 feet below the crown. Flap gate on the waterside (WS) end. Concrete headwall on the landside (LS) end. Concrete U-shaped headwall on the WS end. [Additional Reference(s): DWR Levee Log, 2002, (HLM 19.46). USACE San Joaquin O&M Manual, Unit No. 601, Part No. 1, 1967, Amended in 1978, Revised 20 June 1985, (HLM 19.46). DWR As-Built Specification No. 64-01, Sheet No. 3, 6 November 1963, (HLM 19.46)].

Levee crown.

WS view: Headwall and slope from toe.

WS view: Closeup of flapgate at toe.

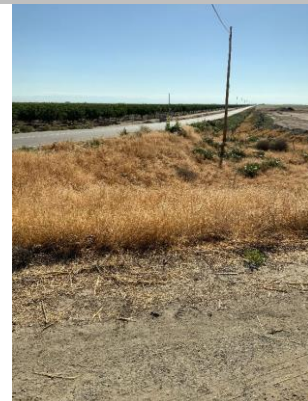
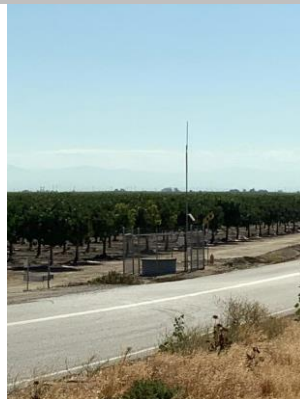
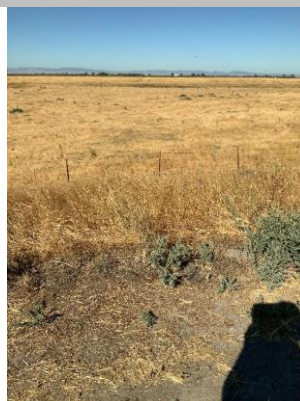
FS_ID:71038
 DS_ID:24868
 EP_NO: N/A
 Repair Type: Non-Urgent
 Crossing Status: Indicator Found
 UCIP Comments: 06/23/2021 The record remains Non-Urgent. As a safety measure, need to coordinate with owner to determine status of line and to obtain maintenance and inspection records to confirm integrity of line through the levee. No markers or signs visible on LS or WS, recommend putting up signage. No permit was found authorizing this encroachment. CVFPB will need to review crossing to determine owner. The UCIP inspection was completed with GEI staff, P. Espinoza. (H. Dunn ? GEI) 04/23/2014 Markers closer to the levee may be necessary to properly mark pipe crossing location. (DWR UCIP - W. Wylie)
 FIELD_STRUCT_DESC: Steel natural gas pipeline of an unknown size through the levee, at an unknown depth. Corrugated metal pipe (CMP) riser unit and gas line marker off the landside (LS) toe.
 FS Date: 6/23/2021

LS view: Toe from crown, no marker visible.

LS view: Marker visible across the road.

WS view: Toe from crown, no markers visible.

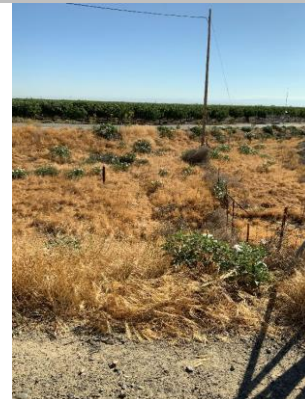
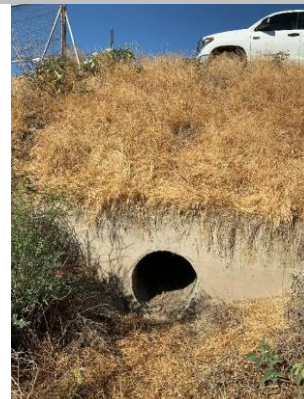
Comment Code						
Inspector Comment						
FS_ID:71039 DS_ID:19778 EP_NO: N/A Repair Type: Non-Urgent Crossing Status: Found UCIP Comments: 06/23/2021 The record remains Non-Urgent. DWR DMP internal inspection has not found pipe integrity issues. LOF of crossing is less or equal to 4.0. Recommend next video inspection in 5 years. No permit was found authorizing this encroachment. CVFPB will need to review crossing to determine owner. The UCIP inspection was completed with GEI staff, P. Espinoza. (H. Dunn ? GEI) 04/23/2014 Dense vegetation limits the inspector's visibility to identify signs of pipe failure (leaks) along the landward slope. Recommend removing vegetation along pipe alignment to conduct proper inspection of structure. Sediment buildup in pipe visible from landward side-- recommend contacting owner to clear pipe. (W. Wylie - DWR UCIP) FIELD_STRUCT_DESC: 24-inch corrugated metal gravity drainage pipe (CMP) through the levee, 9.7 feet below the crown. Flap gate on the waterside (WS) end. Concrete headwall on the landside (LS) end. Concrete U-shaped headwall on the WS end. [Additional Reference(s): DWR Levee Log, 2002, (HLM 19.50). USACE San Joaquin O&M Manual, Unit No. 601, Part No. 1, 1967, Amended in 1978, Revised 20 June 1985, (HLM 19.50). DWR As-Built Specification No. 64-01, Sheet No. 3, 6 November 1963, (HLM 19.50)]. FS Date: 6/23/2021

Levee crown.

LS view: Toe from crown.

LS view: Headwall and slope at toe.

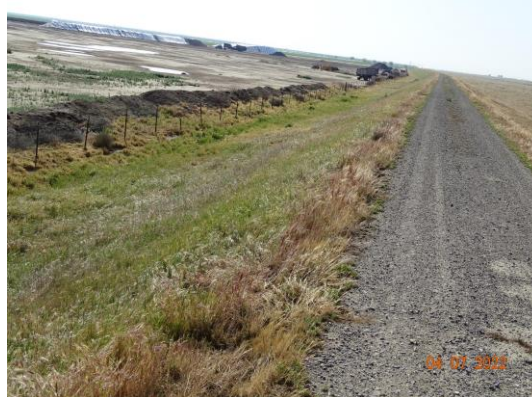
Photo 1 of 1 : SP_2022_NA0010_123_174_20220414_00375.jpg

LM Start	19.53	Rating **	M	Issue No.	174
LM End	23.25	Issue Type +	Ma	Location *	LS
Category	Earthen Levee			GPS Latitude/Longitude	
				Start	End
Item	Vegetation			37.112919 °	37.072942 °
				-120.559775 °	-120.516641 °
DWR ID	DWR_NA0010_05_s_2022_174				
Comment Code					
V1 : Control annual grass and weeds on the levee slopes and easements.					
Inspector Comment

View of the landside slope looking upstream. (Spring 2022)

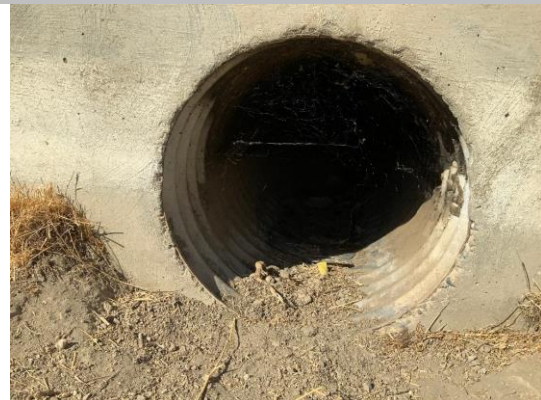
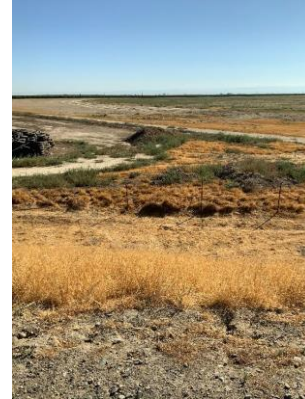
Comment Code						
Inspector Comment						
FS_ID:71040 DS_ID:19779 EP_NO: N/A Repair Type: Urgent Crossing Status: Found UCIP Comments: 06/23/2021 The record has been upgraded from No Action Needed to Urgent. DWR DMP internal inspection has found pipe integrity issues. LOF of crossing is greater than or equal to 5 and less than 6. Crossing will be monitored until funding becomes available to address the issues. WS flapgate has holes in it. LS pipe inlet has some minor debris buildup. No permit was found authorizing this encroachment. CVFPB will need to review crossing to determine owner. The UCIP inspection was completed with GEI staff, P. Espinoza. (H. Dunn ? GEI) FIELD_STRUCT_DESC: 24-inch corrugated metal gravity drainage pipe (CMP) through the levee, 10.3 feet below the crown. Flap gate on the waterside (WS) end. Concrete headwall on the landside (LS) end. Concrete U-shaped headwall on the WS end. [Additional Reference(s): DWR Levee Log, 2002, (HLM 19.83). USACE San Joaquin O&M Manual, Unit No. 601, Part No. 1, 1967, Amended in 1978, Revised 20 June 1985, (HLM 19.84). DWR As-Built Specification No. 64-01, Sheet No. 4, 6 November 1963, (HLM 19.84)]. FS Date: 6/23/2021

Levee crown.

LS view: Closeup of pipe inlet at toe.

LS view: Toe from crown.

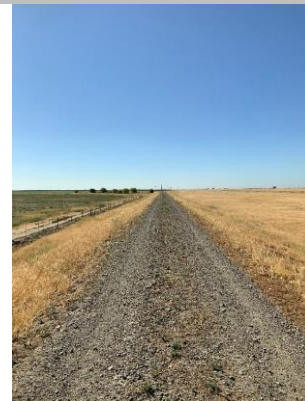
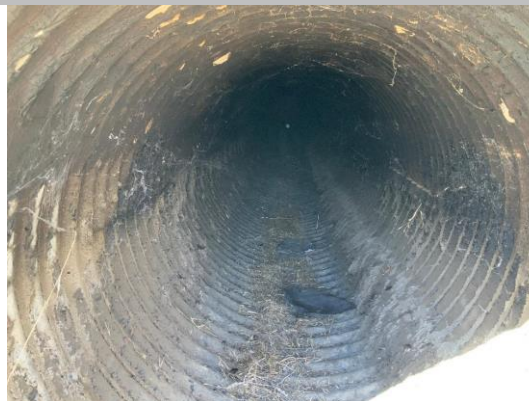
FS_ID:71041
 DS_ID:19780
 EP_NO: N/A
 Repair Type: Non-Urgent
 Crossing Status: Found
 UCIP Comments: 06/23/2021 The record has been upgraded from No Action Needed to Non-Urgent. DWR DMP internal inspection has not found pipe integrity issues. LOF of crossing is less or equal to 4.0. Recommend next video inspection in 5 years. No permit was found authorizing this encroachment. CVFPB will need to review crossing to determine owner. The UCIP inspection was completed with GEI staff, P. Espinoza. (H. Dunn ? GEI)
 FIELD_STRUCT_DESC: 36-inch corrugated metal gravity drainage pipe (CMP) through the levee, 9.8 feet below the crown. Flap gate on the waterside (WS) end. Concrete headwall on the landside (LS) end. Concrete U-shaped headwall on the WS end. [Additional Reference(s): DWR Levee Log, 2002, (HLM 19.92). USACE San Joaquin O&M Manual, Unit No. 601, Part No. 1, 1967, Amended in 1978, Revised 20 June 1985, (HLM 19.92). DWR As-Built Specification No. 64-01, Sheet No. 4, 6 November 1963, (HLM 19.92)].

Levee crown.

LS view: Toe from crown.

LS view: Inside pipe inlet at toe.

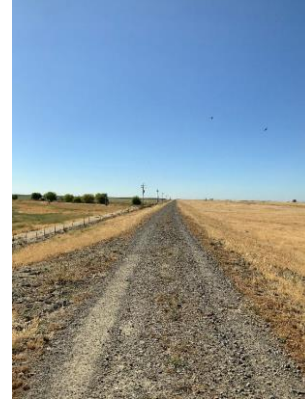
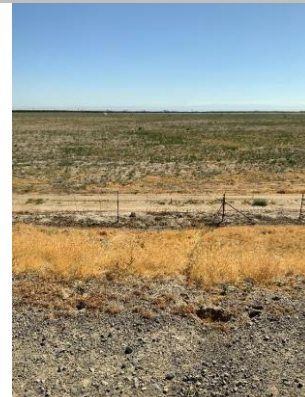
Comment Code						
Inspector Comment						
FS_ID:71042 DS_ID:19781 EP_NO: N/A Repair Type: Non-Urgent Crossing Status: Found UCIP Comments: 06/23/2021 The record has been upgraded from No Action Needed to Non-Urgent. DWR DMP internal inspection has not found pipe integrity issues. LOF of crossing is less or equal to 4.0. Recommend next video inspection in 5 years. No permit was found authorizing this encroachment. CVFPB will need to review crossing to determine owner. The UCIP inspection was completed with GEI staff, P. Espinoza. (H. Dunn ? GEI) FIELD_STRUCT_DESC: 36-inch corrugated metal gravity drainage pipe (CMP) through the levee, 9.9 feet below the crown. Flap gate on the waterside (WS) end. Concrete headwall on the landside (LS) end. Concrete U-shaped headwall on the WS end. [Additional Reference(s): DWR Levee Log, 2002, (HLM 20.04). USACE San Joaquin O&M Manual, Unit No. 601, Part No. 1, 1967, Amended in 1978, Revised 20 June 1985, (HLM 20.05). DWR As-Built Specification No. 64-01, Sheet No. 4, 6 November 1963, (HLM 20.05)]. FS Date: 6/23/2021

Levee crown.

LS view: Toe from crown.

LS view: Slope and headwall from toe.

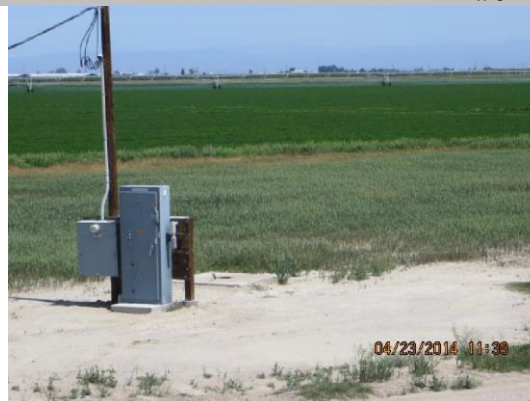
Photo 1 of 1 : UCIP_SP_2022_34759_62537.jpg

FS_ID:34759
 DS_ID:19782
 EP_NO: 13828
 Repair Type: Non-Urgent
 Crossing Status: Not Found
 UCIP Comments:
 FIELD_STRUCT_DESC: *DELETE* NOT INSTALLED THROUGH THE LEVEE. 24-inch steel irrigation pipe through the levee, 4.0 feet below the crown. Pump missing from pad on the landward side. Steel cutoff wall around pipe at center of levee. Siphon breaker on apex of pipe on landward shoulder. Pre-existing ditch runs from waterward toe to channel. Pipe extends from pump to the channel. Rock revetment on the cut slopes of the inlet channel. (Permit No. 13828-1988)
 FS Date: 4/23/2014

Well head visible off LS toe.
