**Flood Control Project Maintenance
Levee Inspections
LMA District Cover Sheet**

Lower San Joaquin Levee District

**Flood Control Project Maintenance
Levee Inspections
Unit Cover Sheet**

Levee Inspection Report By Mile - Spring 2022

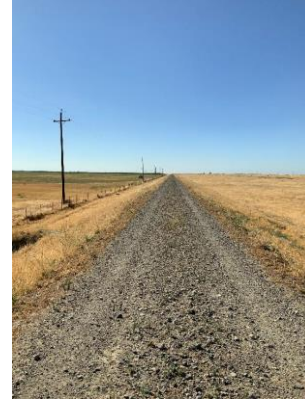
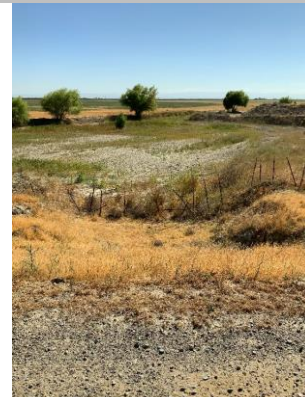
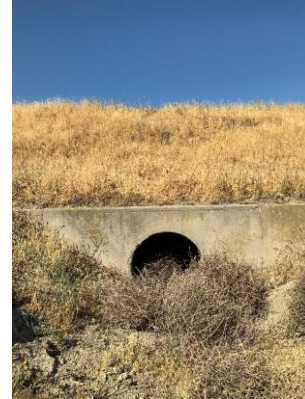
Comment Code					
Inspector Comment					
FS_ID:71043 DS_ID:19783 EP_NO: N/A Repair Type: Non-Urgent Crossing Status: Found UCIP Comments: 06/23/2021 The record has been upgraded from No Action Needed to Non-Urgent. DWR DMP internal inspection has not found pipe integrity issues. LOF of crossing is less or equal to 4.0. Recommend next video inspection in 5 years. Limited inspection of LS pipe inlet due to tumbleweeds, recommend removal. No permit was found authorizing this encroachment. CVFPB will need to review crossing to determine owner. The UCIP inspection was completed with GEI staff, P. Espinoza. (H. Dunn ? GEI) FIELD_STRUCT_DESC: 36-inch corrugated metal gravity drainage pipe (CMP) through the levee, 10.6 feet below the crown. Flap gate on the waterside (WS) end. Concrete headwall on each end. [Additional Reference(s): DWR Levee Log, 2002, (HLM 20.18). USACE San Joaquin O&M Manual, Unit No. 601, Part No. 1, 1967, Amended in 1978, Revised 20 June 1985, (HLM 20.18). DWR As-Built Specification No. 64-01, Sheet No. 4, 6 November 1963, (HLM 20.18)]. FS Date: 6/23/2021

Levee crown.

LS view: Toe from crown.

LS view: Slope and headwall from toe.

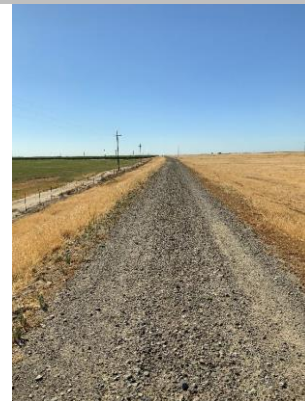
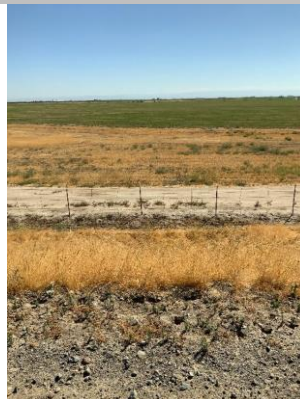
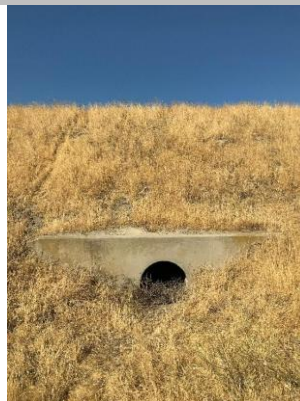
FS_ID:71044
DS_ID:19784
EP_NO: N/A
Repair Type: Urgent
Crossing Status: Found
UCIP Comments: 06/23/2021 The record has been upgraded from Non-Urgent to Urgent. DWR DMP internal inspection has found pipe integrity issues. LOF of crossing is is greater than or equal to 5 and less than 6. Crossing will be monitored until funding becomes available to address the issues. Some tumbleweed buildup at LS pipe inlet, recommend removal. No permit was found authorizing this encroachment. CVFPB will need to review crossing to determine owner. The UCIP inspection was completed with GEI staff, P. Espinoza. (H. Dunn ? GEI)04/23/2014 Dense vegetation limits the inspector's visibility to identify signs of pipe failure (leaks) along the landward slope. Recommend removing vegetation along pipe alignment to conduct proper inspection of structure. (W. Wylie - DWR UCIP)
FIELD_STRUCT_DESC: 24-inch corrugated metal gravity drainage pipe (CMP) through the levee, 10.5 feet below the crown. Flap gate on the waterside (WS) end. Concrete headwall on the landside (LS) end. Concrete U-shaped headwall on the WS end. [Additional Reference(s): DWR Levee Log, 2002, (HLM 20.58). USACE San Joaquin O&M Manual, Unit No. 601, Part No. 1, 1967, Amended in 1978, Revised 20 June 1985, (HLM 20.59). DWR As-Built Specification No. 64-01, Sheet No. 4, 6 November 1963, (HLM 20.59)].

Levee crown.

LS view: Toe from crown.

LS view: Slope and headwall from toe.

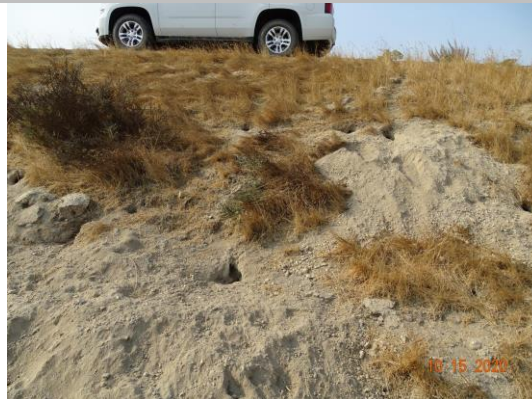
Photo 1 of 1 : SP_2022_NA0010_123_135_20220308_00033.jpg

LM Start	20.93	Rating **	M	Issue No.	135
LM End	20.93	Issue Type +	Ma	Location *	LS
Category	Earthen Levee			GPS Latitude/Longitude	
				Start	End
Item	Animal Control			37.097826 °	37.097826 °
				-120.543984 °	-120.543984 °
DWR ID	DWR_NA0010_05_f_2020_135				
Comment Code					
A3 : No rodents visible, but rodent burrows visible; need to backfill and compact or grout burrows.					
Inspector Comment

View of rodent burrow in the landside slope. (Fall 2020)

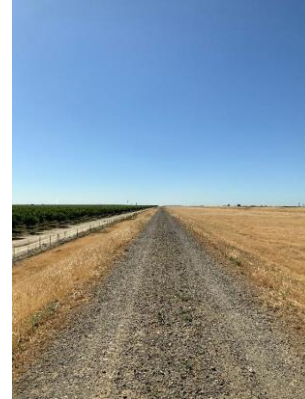
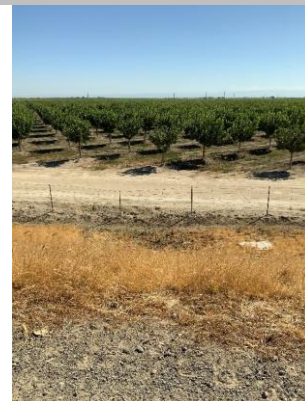
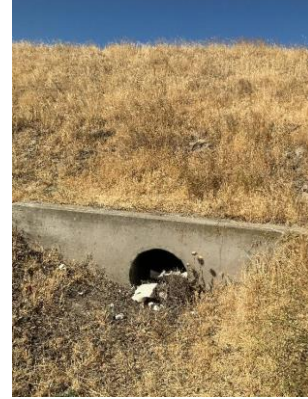
Comment Code						
Inspector Comment						
FS_ID:71045 DS_ID:19785 EP_NO: N/A Repair Type: Urgent Crossing Status: Found UCIP Comments: 06/23/2021 The record is being upgraded from Non-Urgent to Urgent. DWR DMP internal inspection has found pipe integrity issues. LOF of crossing is is greater than or equal to 5 and less than 6. Crossing will be monitored until funding becomes available to address the issues. Tumbleweed and debris covering LS pipe inlet, recommend removal. No permit was found authorizing this encroachment. CVFPB will need to review crossing to determine owner. The UCIP inspection was completed with GEI staff, P. Espinoza. (H. Dunn ? GEI)04/23/2014 Dense vegetation limits the inspector's visibility to identify signs of pipe failure (leaks) along the landward slope. Recommend removing vegetation along pipe alignment to conduct proper inspection of structure. (W. Wylie - DWR UCIP) FIELD_STRUCT_DESC: 24-inch corrugated metal gravity drainage pipe (CMP) through the levee, 11.8 feet below the crown. Flap gate on the waterside (WS) end. Concrete headwall on the landside (LS) end. Concrete U-shaped headwall on the WS end. [Additional Reference(s): DWR Levee Log, 2002, (HLM 21.07). USACE San Joaquin O&M Manual, Unit No. 601, Part No. 1, 1967, Amended in 1978, Revised 20 June 1985, (HLM 21.08). DWR As-Built Specification No. 64-01, Sheet No. 5, 6 November 1963, (HLM 21.08)]. FS Date: 6/23/2021

Levee crown.

LS view: Toe from crown.

LS view: Slope and headwall from toe.

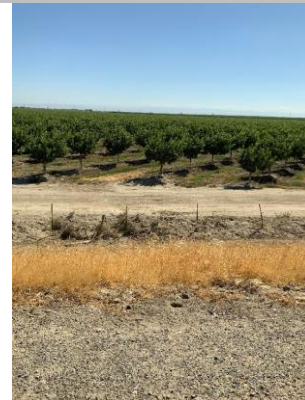
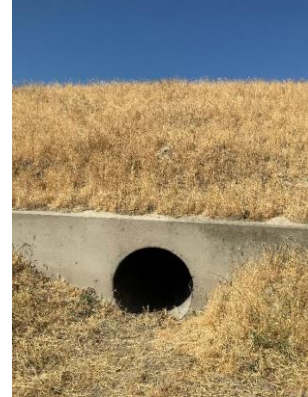
Comment Code						
Inspector Comment						
FS_ID:71046 DS_ID:19786 EP_NO: N/A Repair Type: Urgent Crossing Status: Found UCIP Comments: 06/23/2021 The record has been upgraded from Non-Urgent to Urgent. DWR DMP internal inspection has found pipe integrity issues. LOF of crossing is is greater than or equal to 5 and less than 6. Crossing will be monitored until funding becomes available to address the issues. Potential hole in WS flapgate. Sand buildup around WS flapgate preventing it from opening easily, recommend removal. No permit was found authorizing this encroachment. CVFPB will need to review crossing to determine owner. The UCIP inspection was completed with GEI staff, P. Espinoza. (H. Dunn ? GEI)04/23/2014 Dense vegetation limits the inspector's visibility to identify signs of pipe failure (leaks) along the landward slope. Recommend removing vegetation along pipe alignment to conduct proper inspection of structure. (W. Wylie - DWR UCIP) FIELD_STRUCT_DESC: 36-inch corrugated metal gravity drainage pipe (CMP) through the levee, 12.7 feet below the crown. Flap gate on the waterside (WS) end. Concrete headwall on the landside (LS) end. Concrete U-shaped headwall on the WS end. [Additional Reference(s): DWR Levee Log, 2002, (HLM 21.43). USACE San Joaquin O&M Manual, Unit No. 601, Part No. 1, 1967, Amended in 1978, Revised 20 June 1985, (HLM 21.42). DWR As-Built Specification No. 64-01, Sheet No. 5, 6 November 1963, (HLM 21.42)]. FS Date: 6/23/2021

Levee crown.

LS view: Toe from crown.

LS view: Slope and headwall at toe.

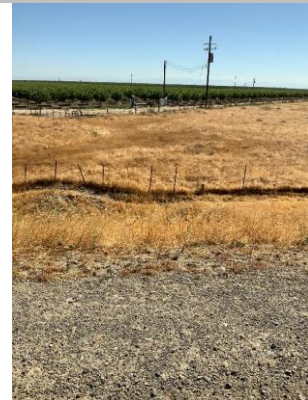
Photo 2 of 3 : UCIP_SP_2022_71048_104206.jpg

LS view: Toe from crown.

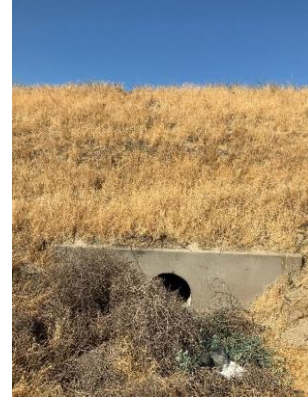
Photo 3 of 3 : UCIP_SP_2022_71048_104203.jpg

LS view: Slope and headwall from toe.

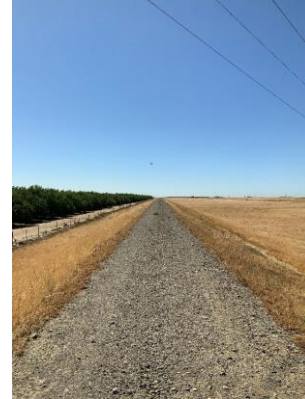
Photo 1 of 3 : UCIP_SP_2022_71049_104212.jpg

Comment Code						
Inspector Comment						
FS_ID:71049 DS_ID:19789 EP_NO: N/A Repair Type: Urgent Crossing Status: Found UCIP Comments: 06/23/2021 The record has been upgraded from Non-Urgent to Urgent. DWR DMP internal inspection has found pipe integrity issues. LOF of crossing is is greater than or equal to 5 and less than 6. Crossing will be monitored until funding becomes available to address the issues. Some vegetation growing over LS pipe inlet, recommend removal. No permit was found authorizing this encroachment. CVFPB will need to review crossing to determine owner. The UCIP inspection was completed with GEI staff, P. Espinoza. (H. Dunn ? GEI)04/23/2014 Dense vegetation limits the inspector's visibility to identify signs of pipe failure (leaks) along the landward slope. Recommend removing vegetation along pipe alignment to conduct proper inspection of structure. Sediment buildup in pipe visible from landward side--recommend contacting owner to clear pipe. (W. Wylie - DWR UCIP) FIELD_STRUCT_DESC: 24-inch corrugated metal gravity drainage pipe (CMP) through the levee, 10.2 feet below the crown. Flap gate on the waterside (WS) end. Concrete headwall on the landside (LS) end. Concrete U-shaped headwall on the WS end. [Additional Reference(s): DWR Levee Log, 2002, (HLM 22.18). USACE San Joaquin O&M Manual, Unit No. 601, Part No. 1, 1967, Amended in 1978, Revised 20 June 1985, (HLM 22.19). DWR As-Built Specification No. 64-01, Sheet No. 5, 6 November 1963, (HLM 22.19)]. FS Date: 6/23/2021

Levee crown.

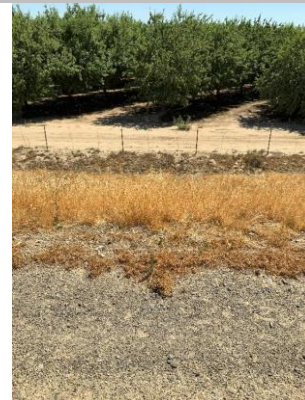
Photo 2 of 3 : UCIP_SP_2022_71050_104221.jpg

LS view: Toe from crown.

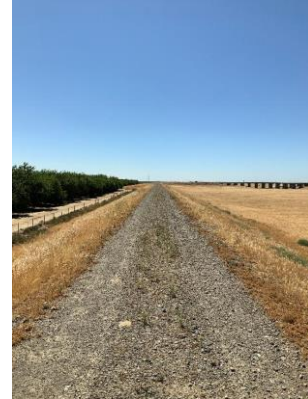
Photo 1 of 3 : UCIP_SP_2022_71051_104227.jpg

Comment Code						
Inspector Comment						
FS_ID:71051 DS_ID:19791 EP_NO: N/A Repair Type: Urgent Crossing Status: Found UCIP Comments: 06/23/2021 The record has been upgraded from Non-Urgent to Urgent. DWR DMP internal inspection has found pipe integrity issues. LOF of crossing is greater than or equal to 5 and less than 6. Crossing will be monitored until funding becomes available to address the issues. Deterioration of the underside of the WS flapgate. No permit was found authorizing this encroachment. CVFPB will need to review crossing to determine owner. The UCIP inspection was completed with GEI staff, P. Espinoza. (H. Dunn ? GEI)04/23/2014 Dense vegetation limits the inspector's visibility to identify signs of pipe failure (leaks) along the landward slope. Recommend removing vegetation along pipe alignment to conduct proper inspection of structure. Sediment buildup in pipe visible from landward side--recommend contacting owner to clear pipe. (W. Wylie - DWR UCIP) FIELD_STRUCT_DESC: 24-inch corrugated metal gravity drainage pipe (CMP) through the levee, 12.2 feet below the crown. Flap gate on the waterside (WS) end. Concrete headwall on the landside (LS) end. Concrete U-shaped headwall on the WS end. [Additional Reference(s): DWR Levee Log, 2002, (HLM 22.79). USACE San Joaquin O&M Manual, Unit No. 601, Part No. 1, 1967, Amended in 1978, Revised 20 June 1985, (HLM 22.79). DWR As-Built Specification No. 64-01, Sheet No. 6, 6 November 1963, (HLM 22.79)]. FS Date: 6/23/2021

Levee crown.

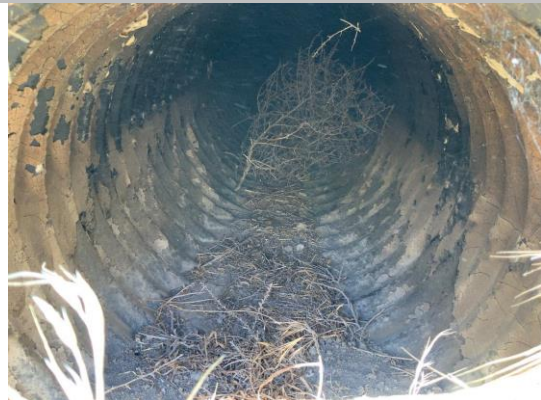
Photo 2 of 3 : UCIP_SP_2022_71051_104228.jpg

LS view: Inside pipe inlet at toe.

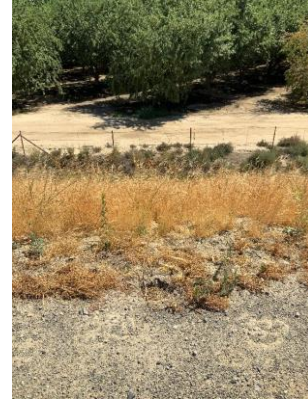
Photo 3 of 3 : UCIP_SP_2022_71051_104230.jpg

LS view: Toe from crown.

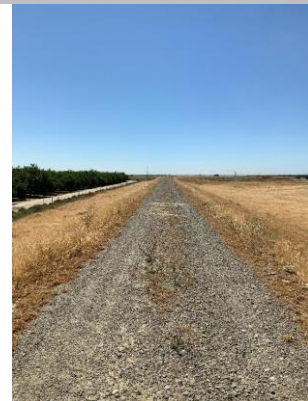
Photo 1 of 3 : UCIP_SP_2022_71052_104235.jpg

FS_ID:71052
 DS_ID:19792
 EP_NO: N/A
 Repair Type: Urgent
 Crossing Status: Found
 UCIP Comments: 06/23/2021 The record has been upgraded from Non-Urgent to Urgent. DWR DMP internal inspection has found pipe integrity issues. LOF of crossing is greater than or equal to 5 and less than 6. Crossing will be monitored until funding becomes available to address the issues. Deterioration of the underside of the WS flapgate. No permit was found authorizing this encroachment. CVFPB will need to review crossing to determine owner. The UCIP inspection was completed with GEI staff, P. Espinoza. (H. Dunn ? GEI)04/23/2014 Dense vegetation limits the inspector's visibility to identify signs of pipe failure (leaks) along the landward slope. Recommend removing vegetation along pipe alignment to conduct proper inspection of structure. (W. Wylie - DWR UCIP)
 FIELD_STRUCT_DESC: 24-inch corrugated metal gravity drainage pipe (CMP) through the levee, 11.1 feet below the crown. Flap gate on the waterside (WS) end. Concrete headwall on the landside (LS) end. Concrete U-shaped headwall on the WS end. [Additional Reference(s): DWR Levee Log, 2002, (HLM 22.93). USACE San Joaquin O&M Manual, Unit No. 601, Part No. 1, 1967, Amended in 1978, Revised 20 June 1985, (HLM 22.94). DWR As-Built Specification No. 64-01, Sheet No. 6, 6 November 1963, (HLM 22.94)].

Levee crown.

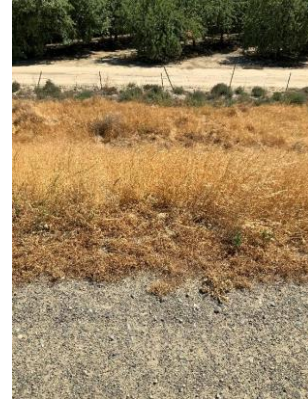
Photo 2 of 3 : UCIP_SP_2022_71052_104237.jpg

LS view: Toe from crown.

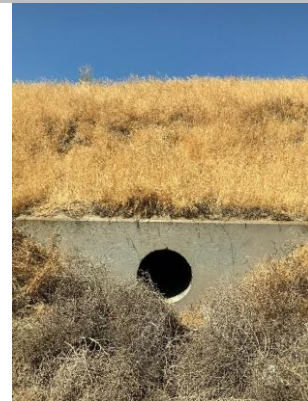
Photo 3 of 3 : UCIP_SP_2022_71052_104233.jpg

LS view: Headwall and slope from toe.

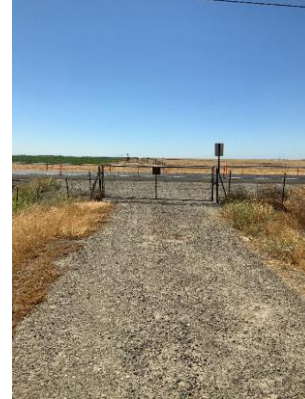
Photo 1 of 3 : UCIP_SP_2022_71053_104335.jpg

Comment Code						
Inspector Comment						
FS_ID:71053 DS_ID:19793 EP_NO: N/A Repair Type: Non-Urgent Crossing Status: Found UCIP Comments: 06/23/2021 The record remains Non-Urgent. DWR DMP internal inspection has not found pipe integrity issues. LOF of crossing is less or equal to 4.0. Recommend next video inspection in 5 years. Some vegetation covering LS inlet and WS flapgate, recommend removal on both ends. No permit was found authorizing this encroachment. CVFPB will need to review crossing to determine owner. The UCIP inspection was completed with GEI staff, P. Espinoza. (H. Dunn ? GEI) 04/23/2014 Debris blocking closure of outlet. Dense vegetation limits the inspector's visibility to identify signs of pipe failure (leaks) along the waterward and landward slopes. Recommend removing vegetation along pipe alignment to conduct proper inspection of structure. (W. Wylie - DWR UCIP) FIELD_STRUCT_DESC: 24-inch corrugated metal gravity drainage pipe (CMP) through the levee, 11.5 feet below the crown. Flap gate on the waterside (WS) end. Concrete headwall on the landside (LS) end. Concrete U-shaped headwall on the WS end. [Additional Reference(s): DWR Levee Log, 2002, (HLM 23.06)]. FS Date: 6/23/2021

Levee crown.

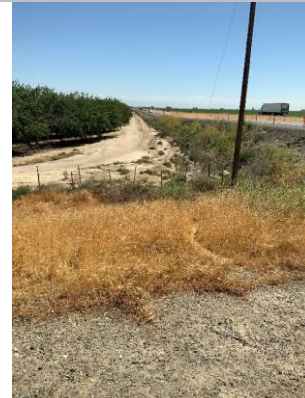
Photo 2 of 3 : UCIP_SP_2022_71053_104337.jpg

LS view: Toe from crown.

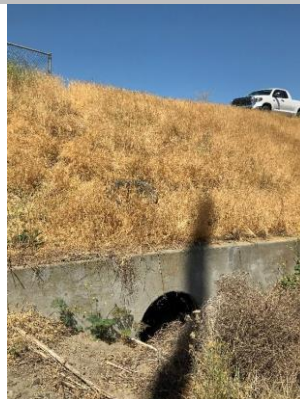
Photo 3 of 3 : UCIP_SP_2022_71053_104333.jpg

LS view: Slope and headwall from toe.

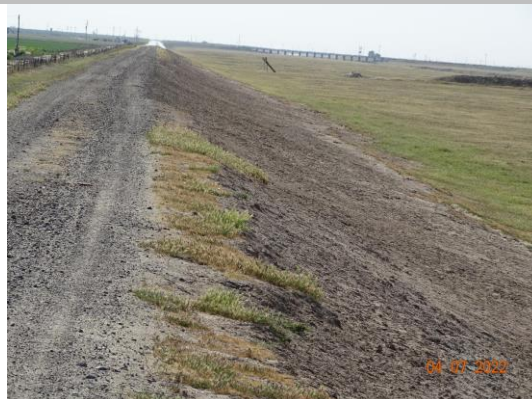
Photo 1 of 1 : SP_2022_NA0010_123_160_20220414_00376.jpg

LM Start	23.24	Rating **	M	Issue No.	160
LM End	23.68	Issue Type +	Ma	Location *	WS
Category	Earthen Levee			GPS Latitude/Longitude	
				Start	End
Item	Erosion / Livestock			37.073064 °	37.068260 °
				-120.516771 °	-120.511583 °
DWR ID	DWR_NA0010_05_f _ 2018_160				
Comment Code					
E4 : Repair the levee slope damaged by livestock and prevent large animal access.					
Inspector Comment					
There is slope damage caused by livestock on waterside.

Slope damage cause by livestock foot traffic. (Spring 2022)

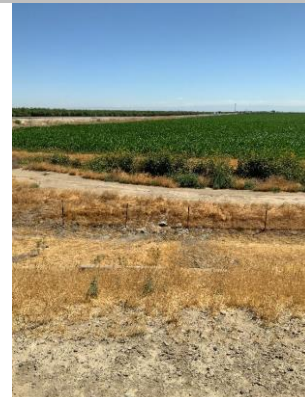
Photo 2 of 3 : UCIP_SP_2022_71054_104343.jpg

LS view: Toe from crown.

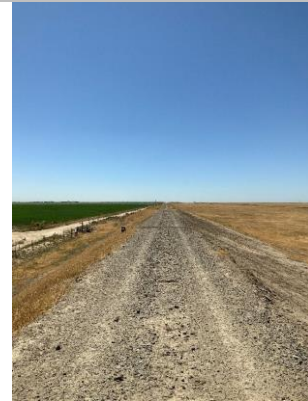
Photo 1 of 3 : UCIP_SP_2022_71055_104367.jpg

FS_ID:71055
 DS_ID:19795
 EP_NO: 13829
 Repair Type: Urgent
 Crossing Status: Found
 UCIP Comments: 06/23/2021 The record has been upgraded from No Action Needed to Urgent. Appears abandoned, WS pipe is missing parts as there are open holes without flapgates that would potentially allow water through, see photos. Open on both ends. Confirm with owner on the status of this pipe. The UCIP inspection was completed with GEI staff, P. Espinoza. (H. Dunn ? GEI)
 FIELD_STRUCT_DESC: 1 of 2: 16-inch coated steel irrigation discharge pipe through the levee, 4.0 feet below the crown. Steel cutoff wall around the pipe at the center of the levee. Slant pump off the waterside (WS) toe. Siphon breaker in a 10-inch steel pipe riser unit on the landside (LS) shoulder. A preexisting ditch runs from the WS toe to the channel. Rock revetment on the cut slopes of the inlet channel. (Pump and 16-inch pipe authorized under Permit No. 13829, 1984 - John H. Sorenson, Inc.). [Additional Reference(s): DWR Levee Log, 2002, (HLM 23.51)].

Levee crown.

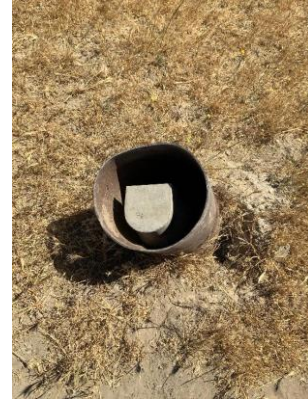
Photo 2 of 3 : UCIP_SP_2022_71055_104369.jpg

LS view: Closeup of siphon breaker on slope.

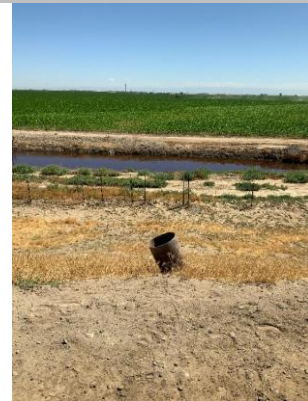
Photo 3 of 3 : UCIP_SP_2022_71055_104370.jpg

LS view: Toe from crown.

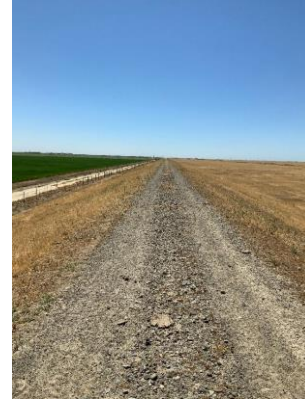
Photo 1 of 3 : UCIP_SP_2022_71057_104379.jpg

Comment Code					
Inspector Comment					
FS_ID:71057 DS_ID:19796 EP_NO: N/A Repair Type: Urgent Crossing Status: Found UCIP Comments: 06/23/2021 The record has been upgraded from Non-Urgent to Urgent. DWR DMP internal inspection has found pipe integrity issues. LOF of crossing is greater than or equal to 5 and less than 6. Crossing will be monitored until funding becomes available to address the issues. No permit was found authorizing this encroachment. CVFPB will need to review crossing to determine owner. The UCIP inspection was completed with GEI staff, P. Espinoza. (H. Dunn ? GEI)03/25/2014 Sediment buildup in pipe visible from landward side-- recommend contacting owner to clear pipe. (W. Wylie - DWR UCIP) FIELD_STRUCT_DESC: 30-inch corrugated metal gravity drainage pipe (CMP) through the levee, 12.1 feet below the crown. Flap gate on the waterside (WS) end. Concrete U-shaped headwall on the WS end. [Additional Reference(s): DWR Levee Log, 2002, (HLM 23.61). USACE San Joaquin O&M Manual, Unit No. 601, Part No. 1, 1967, Amended in 1978, Revised 20 June 1985, (HLM 23.62). DWR As-Built Specification No. 64-01, Sheet No. 7, 6 November 1963, (HLM 23.62)]. FS Date: 6/23/2021

Levee crown.

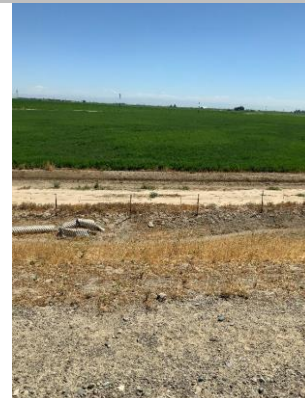
Photo 2 of 3 : UCIP_SP_2022_71057_104380.jpg

LS view: Toe from crown.

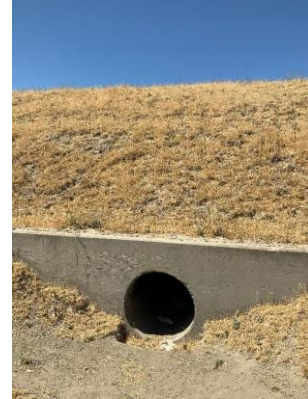
Photo 3 of 3 : UCIP_SP_2022_71057_104377.jpg

LS view: Slope and headwall from toe.

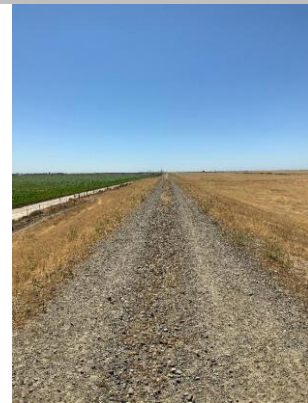
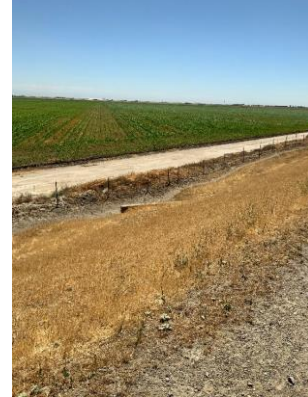
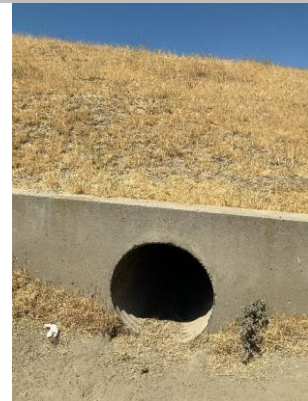
Photo 1 of 3 : UCIP_SP_2022_71058_104386.jpg

FS_ID:71058
 DS_ID:19797
 EP_NO: N/A
 Repair Type: Urgent
 Crossing Status: Found
 UCIP Comments: 06/23/2021 The record has been upgraded from Non-Urgent to Urgent. DWR DMP internal inspection has found pipe integrity issues. LOF of crossing is greater than or equal to 5 and less than 6. Crossing will be monitored until funding becomes available to address the issues. Small hole seen in the front of the WS flapgate. No permit was found authorizing this encroachment. CVFPB will need to review crossing to determine owner. The UCIP inspection was completed with GEI staff, P. Espinoza. (H. Dunn ? GEI)03/25/2014 Minor sediment/debris buildup in pipe visible from landward side--recommend contacting owner to clear pipe. (W. Wylie - DWR UCIP)
 FIELD_STRUCT_DESC: 36-inch corrugated metal gravity drainage pipe (CMP) through the levee, 12.1 feet below the crown. Flap gate on the waterside (WS) end. Concrete headwall on the landside (LS) end. Concrete U-shaped headwall on the WS end. [Additional Reference(s): DWR Levee Log, 2002, (HLM 23.92). USACE San Joaquin O&M Manual, Unit No. 601, Part No. 1, 1967, Amended in 1978, Revised 20 June 1985, (HLM 23.85). DWR As-Built Specification No. 64-01, Sheet No. 7, 6 November 1963, (HLM 23.85)].

Levee crown.

LS view: Toe from crown.

LS view: Slope and headwall from toe.

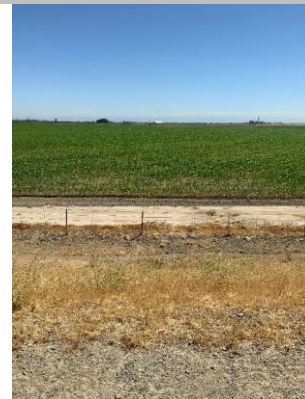
Photo 1 of 3 : UCIP_SP_2022_71059_104393.jpg

Comment Code						
Inspector Comment						
FS_ID:71059						
DS_ID:19798						
EP_NO: N/A						
Repair Type: Non-Urgent						
Crossing Status: Found						
UCIP Comments: 06/23/2021 The record remains Non-Urgent. DWR DMP internal inspection has not found pipe integrity issues. LOF of crossing is less or equal to 4.0. Recommend next video inspection in 5 years. No permit was found authorizing this encroachment. CVFPB will need to review crossing to determine owner. The UCIP inspection was completed with GEI staff, P. Espinoza. (H. Dunn ? GEI) 03/25/2014 Dense vegetation limits the inspector's visibility to identify signs of pipe failure (leaks) along the landward slope. Recommend removing vegetation along pipe alignment to conduct proper inspection of structure. (W. Wylie - DWR UCIP)						
FIELD_STRUCT_DESC: 24-inch corrugated metal gravity drainage pipe (CMP) through the levee, 11.2 feet below the crown. Flap gate on the waterside (WS) end. Concrete headwall on the landside (LS) end. Concrete U-shaped headwall on the WS end. [Additional Reference(s): DWR Levee Log, 2002, (HLM 24.18). USACE San Joaquin O&M Manual, Unit No. 601, Part No. 1, 1967, Amended in 1978, Revised 20 June 1985, (HLM 24.18). DWR As-Built Specification No. 64-01, Sheet No. 7, 6 November 1963, (HLM 24.18)].

Levee crown.

LS view: Toe from crown.

LS view: Slope and headwall from toe.

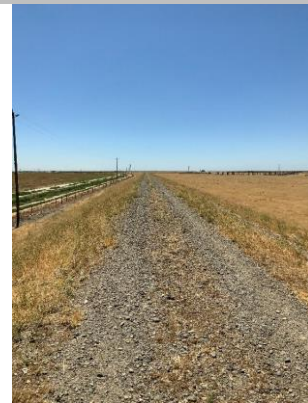
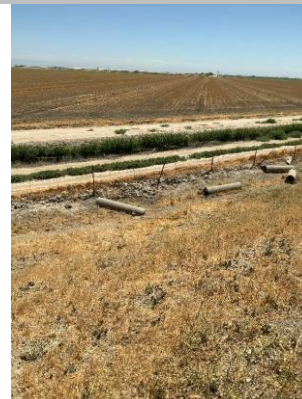
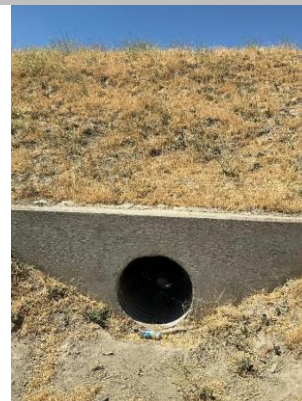
Photo 1 of 3 : UCIP_SP_2022_71060_104402.jpg

FS_ID:71060
 DS_ID:19799
 EP_NO: N/A
 Repair Type: Urgent
 Crossing Status: Found
 UCIP Comments: 06/23/2021 The record has been upgraded from Non-Urgent to Urgent. DWR DMP internal inspection has found pipe integrity issues. LOF of crossing is greater than or equal to 5 and less than 6. Crossing will be monitored until funding becomes available to address the issues. Hole visible on underneath of flapgate on WS. No permit was found authorizing this encroachment. CVFPB will need to review crossing to determine owner. The UCIP inspection was completed with GEI staff, P. Espinoza. (H. Dunn ? GEI)03/25/2014 Dense vegetation limits the inspector's visibility to identify signs of pipe failure (leaks) along the landward slope. Recommend removing vegetation along pipe alignment to conduct proper inspection of structure. (W. Wylie - DWR UCIP)
 FIELD_STRUCT_DESC: 24-inch corrugated metal gravity drainage pipe (CMP) through the levee, 11.2 feet below the crown. Flap gate on the waterside (WS) end. Concrete headwall on the landside (LS) end. Concrete U-shaped headwall on the WS end. [Additional Reference(s): DWR Levee Log, 2002, (HLM 24.46). USACE San Joaquin O&M Manual, Unit No. 601, Part No. 1, 1967, Amended in 1978, Revised 20 June 1985, (HLM 24.46). DWR As-Built Specification No. 64-01, Sheet No. 7, 6 November 1963, (HLM 24.46)].

Levee crown.

LS view: Toe from crown.

LS view: Slope and headwall from toe.

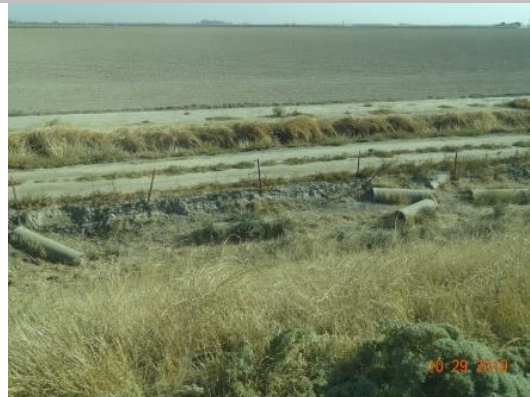
Photo 1 of 1 : SP_2022_NA0010_123_175_20220308_00060.jpg

LM Start	24.56	Rating **	M	Issue No.	175
LM End	24.56	Issue Type +	En	Location *	LS
Category	Earthen Levee			GPS Latitude/Longitude	
				Start	End
Item	Encroachments			37.058672 °	37.058672 °
				-120.501218 °	-120.501218 °
DWR ID	DWR_NA0010_05_f_2019_175				
Comment Code					
PI : Pipe					
Inspector Comment					
Concrete pipe left on landside toe.

Sections of concrete pipe left along the landside toe. (Fall 2019)

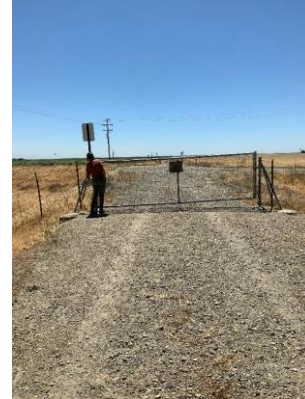
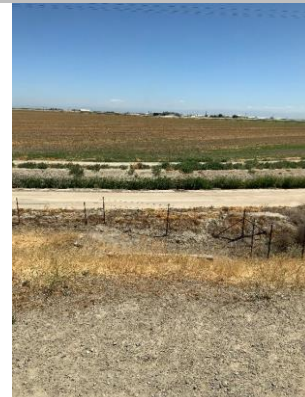
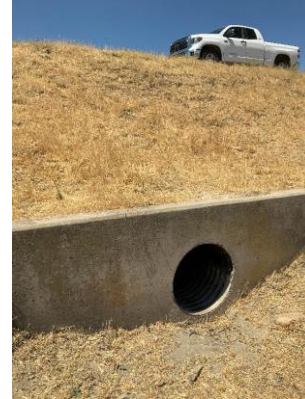
Photo 1 of 3 : UCIP_SP_2022_71061_104409.jpg

Comment Code						
Inspector Comment						
FS_ID:71061 DS_ID:19800 EP_NO: N/A Repair Type: Non-Urgent Crossing Status: Found UCIP Comments: 06/23/2021 The record has been upgraded from No Action Needed to Non-Urgent. DWR DMP internal inspection has not found pipe integrity issues. LOF of crossing is less or equal to 4.0. Recommend next video inspection in 5 years. No permit was found authorizing this encroachment. CVFPB will need to review crossing to determine owner. The UCIP inspection was completed with GEI staff, P. Espinoza. (H. Dunn ? GEI) FIELD_STRUCT_DESC: 24-inch corrugated metal gravity drainage pipe (CMP) through the levee, 10.7 feet below the crown. Flap gate on the waterside (WS) end. Concrete headwall on the landside (LS) end. Concrete U-shaped headwall on the WS end. [Additional Reference(s): DWR Levee Log, 2002, (HLM 24.82). USACE San Joaquin O&M Manual, Unit No. 601, Part No. 1, 1967, Amended in 1978, Revised 20 June 1985, (HLM 24.82). DWR As-Built Specification No. 64-01, Sheet No. 7, 6 November 1963, (HLM 24.82)]. FS Date: 6/23/2021

Levee crown.

LS view: Toe from crown.

LS view: Slope and headwall from toe.

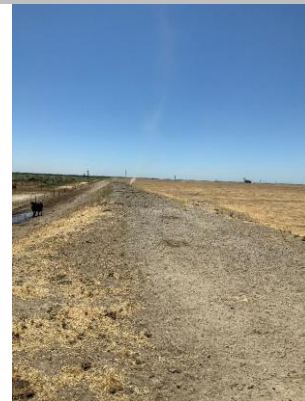
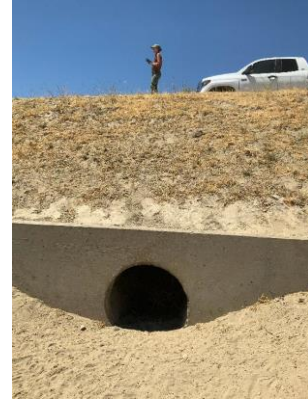
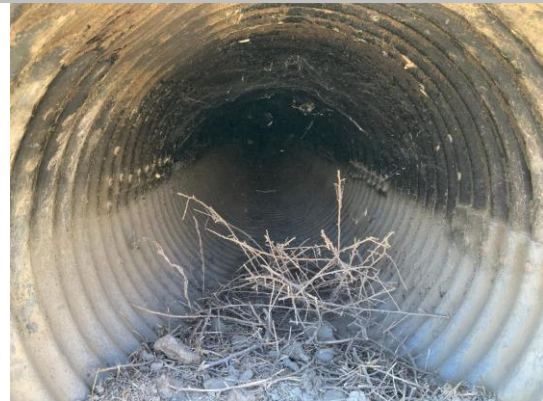
Photo 1 of 3 : UCIP_SP_2022_71062_104416.jpg

FS_ID:71062
DS_ID:19801
EP_NO: N/A
Repair Type: Non-Urgent
Crossing Status: Found
UCIP Comments: 06/23/2021 The record has been upgraded from No Action Needed to Non-Urgent. DWR DMP internal inspection has not found pipe integrity issues. LOF of crossing is less or equal to 4.0. Recommend next video inspection in 5 years. No permit was found authorizing this encroachment. CVFPB will need to review crossing to determine owner. The UCIP inspection was completed with GEI staff, P. Espinoza. (H. Dunn ? GEI)
FIELD_STRUCT_DESC: 30-inch corrugated metal gravity drainage pipe (CMP) through the levee, 10.9 feet below the crown. Flap gate on the waterside (WS) end. Concrete headwall on the landside (LS) end. Concrete U-shaped headwall on the WS end. [Additional Reference(s): DWR Levee Log, 2002, (HLM 24.86). USACE San Joaquin O&M Manual, Unit No. 601, Part No. 1, 1967, Amended in 1978, Revised 20 June 1985, (HLM 24.87). DWR As-Built Specification No. 64-01, Sheet No. 7, 6 November 1963, (HLM 24.87)].

Levee crown.

LS view: Slope and headwall from toe.

LS view: Inside pipe inlet at toe.

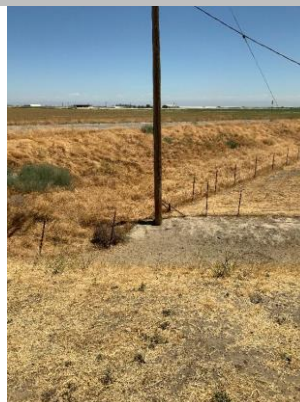
Photo 1 of 3 : UCIP_SP_2022_71063_104493.jpg

Comment Code					
Inspector Comment					
FS_ID:71063 DS_ID:19802 EP_NO: 12873 Repair Type: Non-Urgent Crossing Status: Found UCIP Comments: 06/23/2021 The record remains Non-Urgent. Appears abandoned, did not find valve or electrical panel on LS. Confirm with owner on the status of this crossing. The UCIP inspection was completed with GEI staff, P. Espinoza. (H. Dunn ? GEI) 03/25/2014 Clear soil from siphon breaker and install a protective riser. (W. Wylie - DWR UCIP) FIELD_STRUCT_DESC: 16-inch coated steel irrigation discharge pipe through the levee, 2.0 feet below the crown. Slant pump at the channel on the waterside (WS) toe. Siphon breaker on the WS shoulder. Gate valve on the landside (LS) toe. A preexisting ditch runs from the WS toe to the channel. Riprap placed around the intake. 2-inch polyvinyl chloride (PVC) electrical conduit at the same location. (Pump and pipe authorized under Permit No. 12873, 1980 - Bowles Farming Company). [Additional Reference(s): DWR Levee Log, 2002, (HLM 24.88)]. FS Date: 6/23/2021

Levee crown.

LS view: Toe from crown, no valve visible.

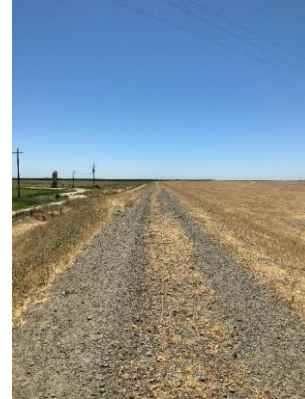
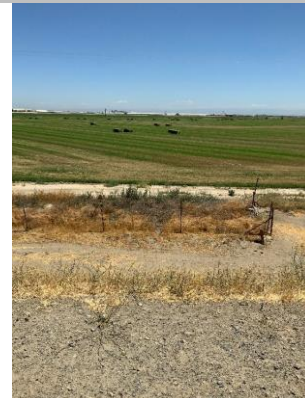
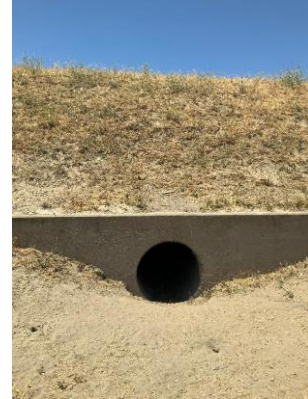
Photo 1 of 3 : UCIP_SP_2022_71064_104424.jpg

Comment Code					
Inspector Comment					
FS_ID:71064 DS_ID:19803 EP_NO: N/A Repair Type: Non-Urgent Crossing Status: Found UCIP Comments: 06/23/2021 The record remains Non-Urgent. DWR DMP internal inspection has not found pipe integrity issues. LOF of crossing is less or equal to 4.0. Recommend next video inspection in 5 years. No permit was found authorizing this encroachment. CVFPB will need to review crossing to determine owner. The UCIP inspection was completed with GEI staff, P. Espinoza. (H. Dunn ? GEI) 03/25/2014 Flapgate propped open during flood season. (W. Wylie - DWR UCIP) FIELD_STRUCT_DESC: 30-inch corrugated metal gravity drainage pipe (CMP) through the levee, 11.3 feet below the crown. Flap gate on the waterside (WS) end. Concrete headwall on the landside (LS) end. Concrete U-shaped headwall on the WS end. [Additional Reference(s): DWR Levee Log, 2002, (HLM 25.14). USACE San Joaquin O&M Manual, Unit No. 601, Part No. 1, 1967, Amended in 1978, Revised 20 June 1985, (recorded incorrectly as HLM 25.43, should be 25.13). DWR As-Built Specification No. 64-01, Sheet No. 8, 6 November 1963, (HLM 25.13)]. FS Date: 6/23/2021

Levee crown.

LS view: Toe from crown.

LS view: Slope and headwall from toe.

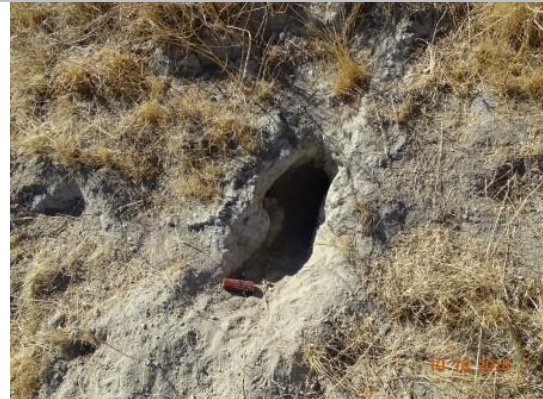
Photo 1 of 1 : SP_2022_NA0010_123_9_20220308_00007.jpg

LM Start	25.28	Rating **	M	Issue No.	9
LM End	25.35	Issue Type +	Ma	Location *	LS
Category	Earthen Levee			GPS Latitude/Longitude	
				Start	End
Item	Animal Control			37.051076 °	37.050349 °
				-120.492153 °	-120.491269 °
DWR ID	DWR_NA0010_05_s_2012_9				
Comment Code					
A1 : Exterminate rodents and backfill and compact or grout burrows.					
Inspector Comment					
Several rodent holes are noted along this section.

View of representative rodent burrow. (Fall 2018)

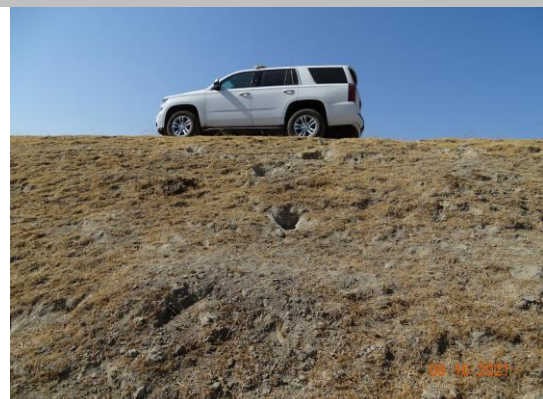
Photo 1 of 1 : SP_2022_NA0010_123_167_20220308_00055.jpg

LM Start	25.46	Rating **	M	Issue No.	167
LM End	25.52	Issue Type +	Ma	Location *	LS
Category	Earthen Levee			GPS Latitude/Longitude	
				Start	End
Item	Animal Control			37.049218 °	37.048502 °
				-120.489883 °	-120.489257 °
DWR ID	DWR_NA0010_05_f_2021_167				
Comment Code					
A3 : No rodents visible, but rodent burrows visible; need to backfill and compact or grout burrows.					
Inspector Comment

Multiple rodent holes observed on the landside slope. (Fall 2021)

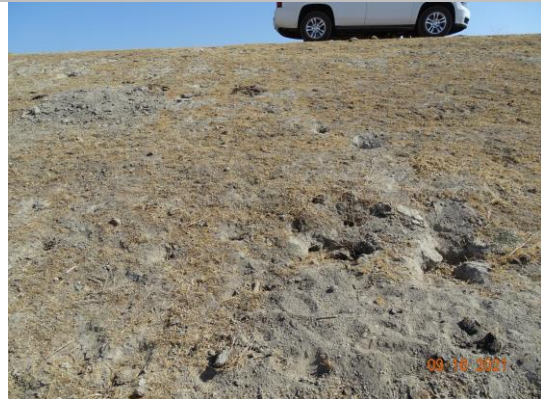
Photo 1 of 1 : SP_2022_NA0010_123_168_20220308_00056.jpg

LM Start	25.46	Rating **	M	Issue No.	168
LM End	25.46	Issue Type +	Ma	Location *	WS
Category	Earthen Levee			GPS Latitude/Longitude	
				Start	End
Item	Animal Control			37.049217 °	37.049217 °
				-120.489881 °	-120.489881 °
DWR ID	DWR_NA0010_05_f_2021_168				
Comment Code					
A3 : No rodents visible, but rodent burrows visible; need to backfill and compact or grout burrows.					
Inspector Comment

View of rodent burrows on the waterside slope. (Fall 2021)

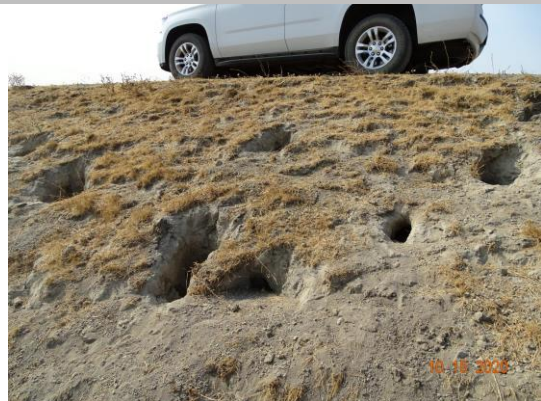
Photo 1 of 1 : SP_2022_NA0010_123_148_20220308_00042.jpg

LM Start	25.58	Rating **	U	Issue No.	148
LM End	25.60	Issue Type +	Ma	Location *	LS
Category	Earthen Levee			GPS Latitude/Longitude	
				Start	End
Item	Animal Control			37.047827 °	37.047551 °
				-120.488738 °	-120.488527 °
DWR ID	DWR_NA0010_05_f_2020_148				
Comment Code					
A3 : No rodents visible, but rodent burrows visible; need to backfill and compact or grout burrows.					
Inspector Comment

View of burrows in the landside. (Fall 2020)

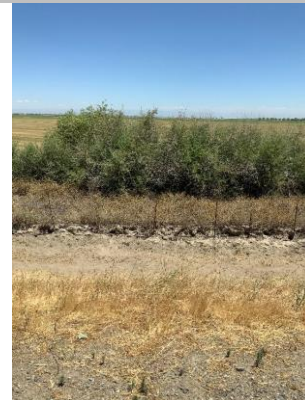
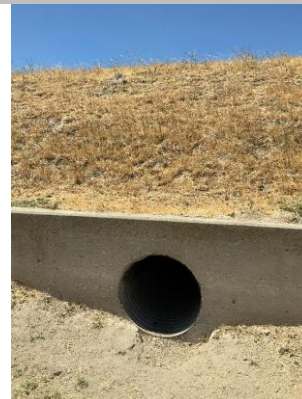
Photo 1 of 3 : UCIP_SP_2022_71065_104431.jpg

Comment Code						
Inspector Comment						
FS_ID:71065 DS_ID:19804 EP_NO: N/A Repair Type: Urgent Crossing Status: Found UCIP Comments: 06/23/2021 The record has been upgraded from Non-Urgent to Urgent. DWR DMP internal inspection has found pipe integrity issues. LOF of crossing is greater than or equal to 5 and less than 6. Crossing will be monitored until funding becomes available to address the issues. No permit was found authorizing this encroachment. CVFPB will need to review crossing to determine owner. The UCIP inspection was completed with GEI staff, P. Espinoza. (H. Dunn ? GEI)03/25/2014 Dense vegetation limits the inspector's visibility to identify signs of pipe failure (leaks) along the landward slope. Recommend removing vegetation along pipe alignment to conduct proper inspection of structure. Sediment buildup in pipe visible from landward side--recommend contacting owner to clear pipe. (W. Wylie - DWR UCIP) FIELD_STRUCT_DESC: 30-inch corrugated metal gravity drainage pipe (CMP) through the levee, 12.0 feet below the crown. Flap gate on the waterside (WS) end. Concrete headwall on the landside (LS) end. Concrete U-shaped headwall on the WS end. [Additional Reference(s): DWR Levee Log, 2002, (HLM 25.51). USACE San Joaquin O&M Manual, Unit No. 601, Part No. 1, 1967, Amended in 1978, Revised 20 June 1985, (HLM 25.51). DWR As-Built Specification No. 64-01, Sheet No. 8, 6 November 1963, (HLM 25.51)]. FS Date: 6/23/2021

Levee crown.

LS view: Toe from crown.

LS view: Slope and headwall from toe.

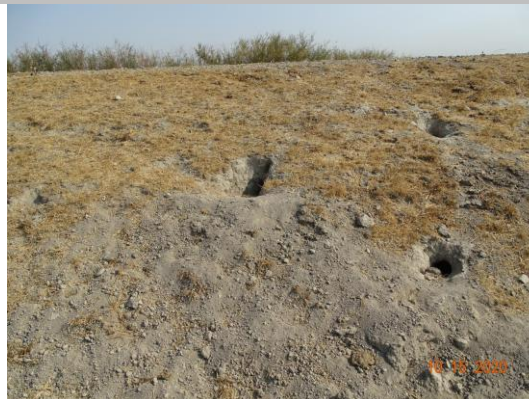
Photo 1 of 1 : SP_2022_NA0010_123_124_20220308_00024.jpg

LM Start	25.61	Rating **	M	Issue No.	124
LM End	25.61	Issue Type +	Ma	Location *	WS
Category	Earthen Levee			GPS Latitude/Longitude	
				Start	End
Item	Animal Control			37.047416 °	37.047416 °
				-120.488411 °	-120.488411 °
DWR ID	DWR_NA0010_05_f_2017_124				
Comment Code					
A1 : Exterminate rodents and backfill and compact or grout burrows.					
Inspector Comment

Looking east at the waterside slope. (Fall 2020)

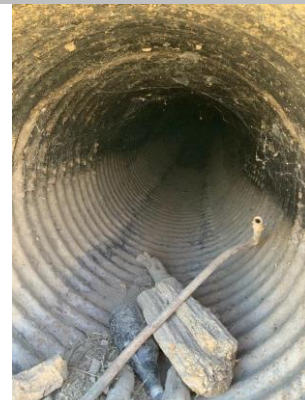
Photo 1 of 3 : UCIP_SP_2022_71066_104436.jpg

Comment Code					
Inspector Comment					
FS_ID:71066 DS_ID:19805 EP_NO: N/A Repair Type: Urgent Crossing Status: Found UCIP Comments: 06/23/2021 The record has been upgraded from Non-Urgent to Urgent. DWR DMP internal inspection has found pipe integrity issues. LOF of crossing is greater than or equal to 5 and less than 6. Crossing will be monitored until funding becomes available to address the issues. No permit was found authorizing this encroachment. CVFPB will need to review crossing to determine owner. The UCIP inspection was completed with GEI staff, P. Espinoza. (H. Dunn ? GEI)03/25/2014 Sediment buildup in pipe visible from landward side-- recommend contacting owner to clear pipe. (W. Wylie - DWR UCIP) FIELD_STRUCT_DESC: 30-inch corrugated metal gravity drainage pipe (CMP) through the levee, 12.1 feet below the crown. Flap gate on the waterside (WS) end. Concrete headwall on the landside (LS) end. Concrete U-shaped headwall on the WS end. [Additional Reference(s): DWR Levee Log, 2002, (HLM 25.53). USACE San Joaquin O&M Manual, Unit No. 601, Part No. 1, 1967, Amended in 1978, Revised 20 June 1985, (HLM 25.53). DWR As-Built Specification No. 64-01, Sheet No. 8, 6 November 1963, (HLM 25.53)]. FS Date: 6/23/2021

Levee crown.

LS view: Inside pipe inlet at toe.

LS view: Slope and headwall from toe.

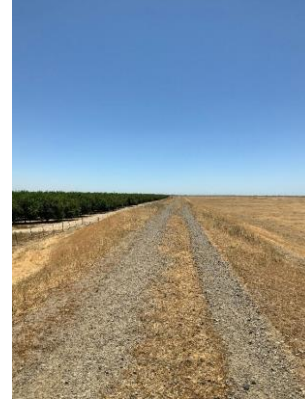
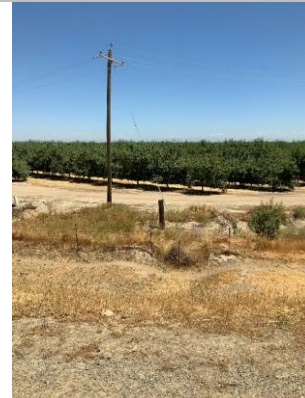
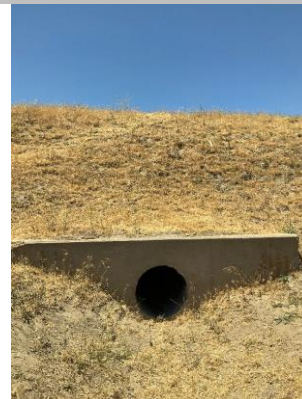
Photo 1 of 3 : UCIP_SP_2022_71067_104450.jpg

Comment Code					
Inspector Comment					
FS_ID:71067 DS_ID:19806 EP_NO: N/A Repair Type: Urgent Crossing Status: Found UCIP Comments: 06/23/2021 The record has been upgraded from Non-Urgent to Urgent. DWR DMP internal inspection has found pipe integrity issues. LOF of crossing is greater than or equal to 5 and less than 6. Crossing will be monitored until funding becomes available to address the issues. No permit was found authorizing this encroachment. CVFPB will need to review crossing to determine owner. The UCIP inspection was completed with GEI staff, P. Espinoza. (H. Dunn ? GEI)03/25/2014 Sediment buildup in pipe visible from landward side-- recommend contacting owner to clear pipe. (W. Wylie - DWR UCIP) FIELD_STRUCT_DESC: 24-inch corrugated metal gravity drainage pipe (CMP) through the levee, 10.0 feet below the crown. Flap gate on the waterside (WS) end. Concrete headwall on the landside (LS) end. Concrete U-shaped headwall on the WS end. [Additional Reference(s): DWR Levee Log, 2002, (HLM 26.10). USACE San Joaquin O&M Manual, Unit No. 601, Part No. 1, 1967, Amended in 1978, Revised 20 June 1985, (HLM 26.11). DWR As-Built Specification No. 64-01, Sheet No. 8, 6 November 1963, (HLM 26.11)]. FS Date: 6/23/2021

Levee crown.

LS view: Toe from crown.

LS view: Slope and headwall from toe.

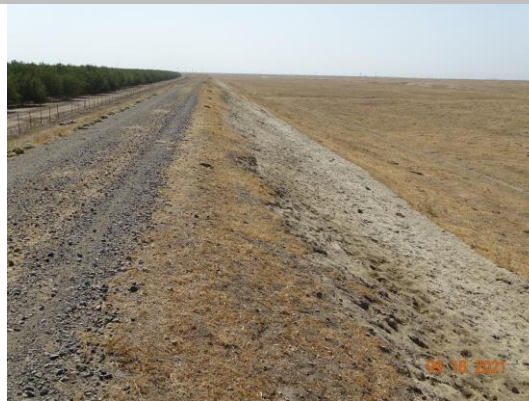
Photo 1 of 1 : SP_2022_NA0010_123_169_20220308_00057.jpg

LM Start	26.30	Rating **	A/W	Issue No.	169
LM End	26.69	Issue Type +	Ma	Location *	WS
Category	Earthen Levee			GPS Latitude/Longitude	
				Start	End
Item	Erosion / Livestock			37.038855 °	37.034140 °
				-120.481877 °	-120.478076 °
DWR ID	DWR_NA0010_05_f_2021_169				
Comment Code					
E4 : Repair the levee slope damaged by livestock and prevent large animal access.					
Inspector Comment					
Damage to the waterside slope from cattle traffic and minor damage on the landside slope.

View of slope damage from cattle traffic. (Fall 2021)

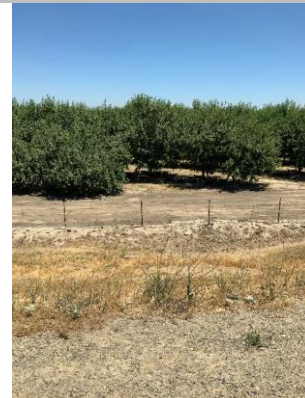
Photo 1 of 3 : UCIP_SP_2022_71068_104455.jpg

Comment Code					
Inspector Comment					
FS_ID:71068 DS_ID:19807 EP_NO: N/A Repair Type: Urgent Crossing Status: Found UCIP Comments: 06/23/2021 The record has been upgraded from No Action Needed to Urgent. DWR DMP internal inspection has found pipe integrity issues. LOF of crossing is greater than or equal to 5 and less than 6. Crossing will be monitored until funding becomes available to address the issues. No permit was found authorizing this encroachment. CVFPB will need to review crossing to determine owner. The UCIP inspection was completed with GEI staff, P. Espinoza. (H. Dunn ? GEI) FIELD_STRUCT_DESC: 36-inch corrugated metal gravity drainage pipe (CMP) through the levee, 13.0 feet below the crown. Flap gate on the waterside (WS) end. Concrete headwall on the landside (LS) end. Concrete U-shaped headwall on the WS end. [Additional Reference(s): DWR Levee Log, 2002, (HLM 26.29). USACE San Joaquin O&M Manual, Unit No. 601, Part No. 1, 1967, Amended in 1978, Revised 20 June 1985, (HLM 26.29). DWR As-Built Specification No. 64-01, Sheet No. 9, 6 November 1963, (HLM 26.29)]. FS Date: 6/23/2021

Levee crown.

LS view: Toe from crown.

LS view: Slope and headwall from toe.

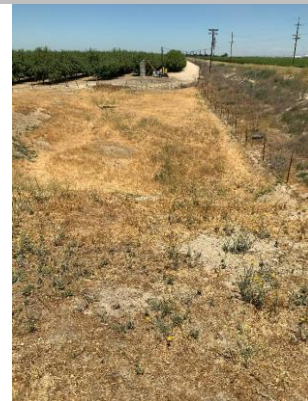
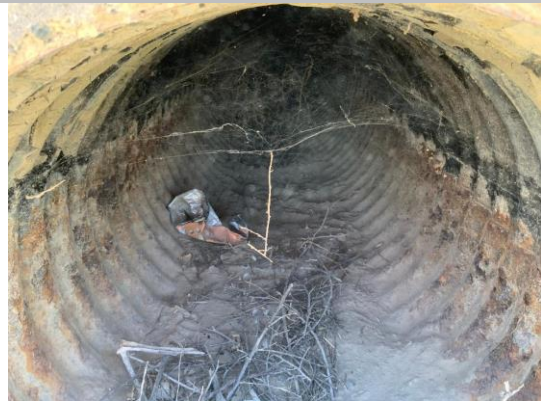
Photo 1 of 3 : UCIP_SP_2022_71069_104461.jpg

FS_ID:71069
 DS_ID:19808
 EP_NO: N/A
 Repair Type: Urgent
 Crossing Status: Found
 UCIP Comments: 06/23/2021 The record has been upgraded from Non-Urgent to Urgent. LOF of crossing is greater than or equal to 5 and less than 6. Crossing will be monitored until funding becomes available to address issues. No permit was found authorizing this encroachment. CVFPB will need to review crossing to determine owner. The UCIP inspection was completed with GEI staff, P. Espinoza. (H. Dunn ? GEI)03/25/2014 Pipe has heavy silt buildup visible from landward side--recommend contacting owner to clear pipe. (W. Wylie - DWR UCIP)
 FIELD_STRUCT_DESC: 24-inch corrugated metal gravity drainage pipe (CMP) through the levee, 11.4 feet below the crown. Flap gate on the waterside (WS) end. Concrete headwall on the landside (LS) end. Concrete U-shaped headwall on the WS end. [Additional Reference(s): DWR Levee Log, 2002, (HLM 26.85). USACE San Joaquin O&M Manual, Unit No. 601, Part No. 1, 1967, Amended in 1978, Revised 20 June 1985, (HLM 26.85). DWR As-Built Specification No. 64-01, Sheet No. 9, 6 November 1963, (HLM 26.85)].

LS view: Toe from crown.

LS view: Slope and headwall from toe.

LS view: Inside of pipe inlet at toe.

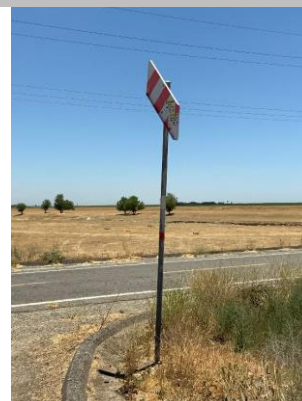
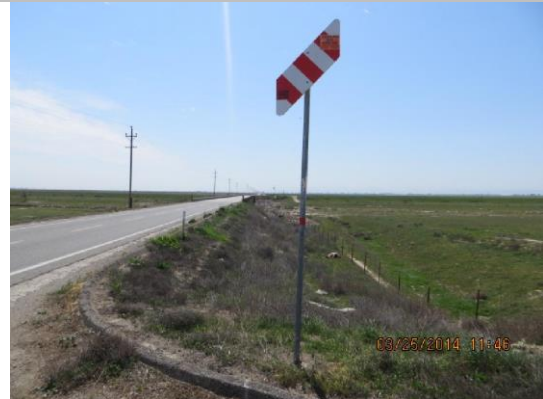
Photo 1 of 3 : UCIP_SP_2022_71070_104467.jpg

Comment Code					
Inspector Comment					
FS_ID:71070 DS_ID:24851 EP_NO: 16002 Repair Type: Non-Urgent Crossing Status: Found UCIP Comments: 06/23/2021 The record has been upgraded from No Action Needed to Non-Urgent. As a safety measure, need to coordinate with owner to determine status of line and to obtain maintenance and inspection records to confirm integrity of line through the levee. No LS markers but one on WS. The UCIP inspection was completed with GEI staff, P. Espinoza. (H. Dunn ? GEI) FIELD_STRUCT_DESC: 8-inch steel natural gas pipeline through the levee, 1.5 feet below the crown. Pipe extends under both levees of the Chowchilla Canal Bypass and the San Joaquin River. Gas line marker on the waterside (WS) shoulder. (8-inch gas line authorized under Permit No. 16002, 1993 - Union Oil Company of California). FS Date: 6/23/2021

Levee crown.

WS view: Marker visible off the crown.

Gasline marker on WS shoulder.

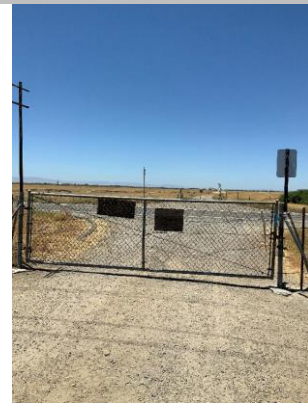
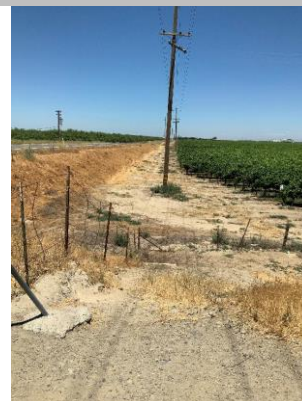
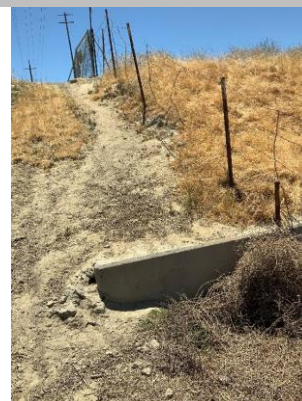
Photo 1 of 3 : UCIP_SP_2022_71071_104358.jpg

FS_ID:71071
 DS_ID:19748
 EP_NO: N/A
 Repair Type: Urgent
 Crossing Status: Found
 UCIP Comments: 06/23/2021 Record has been upgraded from Non-Urgent to Urgent. DWR DMP internal inspection has found pipe integrity issues. LOF of crossing is greater than or equal to 5 and less than 6. Crossing will be monitored until funding becomes available to address the issues. Limited inspection of LS inlet due to dirt and tumbleweeds, recommend removal. Unidentified PVC pipe installed at mouth of inlet pipe on LS. No permit was found authorizing this encroachment. CVFPB will need to review crossing to determine owner. The UCIP inspection was completed with GEI staff, H.Dunn. (P.Espinoza ? GEI)03/25/2014 Tumble weed buildup at inlet mat create blockage and should be removed. (W. Wylie - DWR UCIP)
 FIELD_STRUCT_DESC: 24-inch corrugated metal gravity drainage pipe (CMP) through the levee, 11.3 feet below the crown. Flap gate on the waterside (WS) end. Concrete headwall on the landside (LS) end. Concrete U-shaped headwall on the WS end. [Additional Reference(s): DWR Levee Log, 2002, (HLM 26.87). USACE San Joaquin O&M Manual, Unit No. 601, Part No. 1, 1967, Amended in 1978, Revised 20 June 1985, (HLM 26.87). DWR As-Built Specification No. 64-01, Sheet No. 9, 6 November 1963, (HLM 26.87)].

View from levee crown.

LS view from crown.

LS view from toe: concrete headwall at inlet

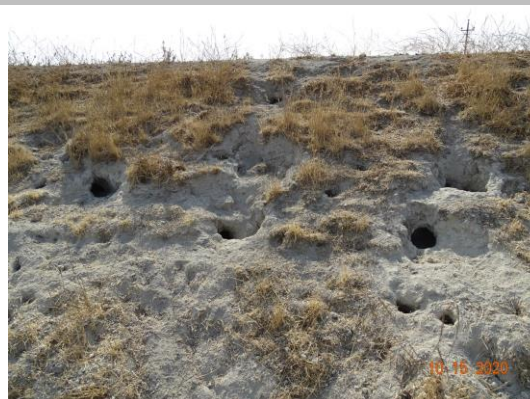
Photo 1 of 1 : SP_2022_NA0010_123_162_20220308_00052.jpg

LM Start	26.99	Rating **	U	Issue No.	162
LM End	27.04	Issue Type +	Ma	Location *	LS
Category	Earthen Levee			GPS Latitude/Longitude	
				Start	End
Item	Animal Control			37.032651 °	37.032659 °
				-120.473205 °	-120.472190 °
DWR ID	DWR_NA0010_05_f_2018_162				
Comment Code					
A1 : Exterminate rodents and backfill and compact or grout burrows.					
Inspector Comment					
Several rodent burrows with large quantities of material displaced noted in this section.

Several rodent burrows noted in this section of the levee. (Fall 2020)

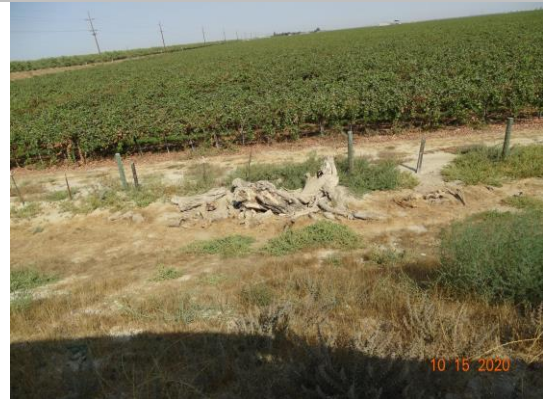
Photo 1 of 1 : SP_2022_NA0010_123_125_20220308_00025.jpg

LM Start	27.01	Rating **	M	Issue No.	125
LM End	27.01	Issue Type +	Ma	Location *	LS
Category	Earthen Levee			GPS Latitude/Longitude	
				Start	End
Item	Encroachments			37.032675 °	37.032675 °
				-120.472841 °	-120.472841 °
DWR ID	DWR_NA0010_05_s_2021_125				
Comment Code					
TR : Tree or limb					
Inspector Comment

Prunings left on the landside toe. (Fall 2020)

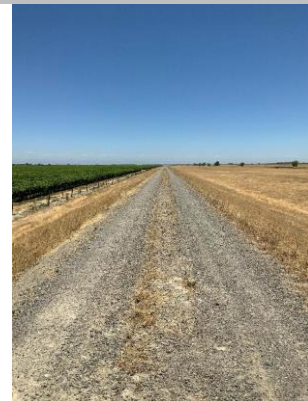
Photo 1 of 3 : UCIP_SP_2022_71072_104352.jpg

Comment Code						
Inspector Comment						
FS_ID:71072 DS_ID:19749 EP_NO: N/A Repair Type: Urgent Crossing Status: Found UCIP Comments: 06/23/2021 The record has been upgraded from No Action Needed to Urgent. DWR DMP internal inspection has found pipe integrity issues. LOF of crossing is greater than or equal to 5 and less than 6. Crossing will be monitored until funding becomes available to address the issues. No permit was found authorizing this encroachment. CVFPB will need to review crossing to determine owner. The UCIP inspection was completed with GEI staff, H.Dunn. (P.Espinoza ? GEI) FIELD_STRUCT_DESC: 36-inch corrugated metal gravity drainage pipe (CMP) through the levee, 12.0 feet below the crown. Flap gate on the waterside (WS) end. Concrete headwall on the landside (LS) end. Concrete U-shaped headwall on the WS end. [Additional Reference(s): DWR Levee Log, 2002, (HLM 27.21). USACE San Joaquin O&M Manual, Unit No. 601, Part No. 1, 1967, Amended in 1978, Revised 20 June 1985, (HLM 27.22). DWR As-Built Specification No. 64-01, Sheet No. 10, 6 November 1963, (HLM 27.22)]. FS Date: 6/23/2021

View from levee crown.

LS view from crown.

LS view from toe: concrete headwall at inlet.
