**Flood Control Project Maintenance
Levee Inspections
LMA District Cover Sheet**

Lower San Joaquin Levee District

**Flood Control Project Maintenance
Levee Inspections
Unit Cover Sheet**

Levee Inspection Report By Mile - Spring 2022

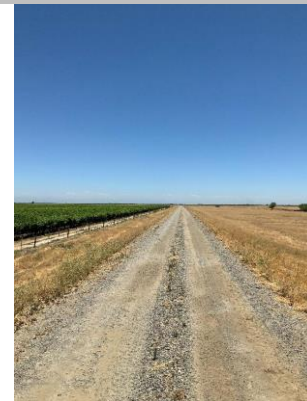
Photo 1 of 3 : UCIP_SP_2022_71073_104347.jpg

Comment Code					
Inspector Comment					
FS_ID:71073 DS_ID:19750 EP_NO: N/A Repair Type: Non-Urgent Crossing Status: Found UCIP Comments: 06/23/2021 The record remains Non-Urgent. DWR DMP internal inspection has not found pipe integrity issues. LOF of crossing is less or equal to 4.0. Recommend next video inspection in 5 years. Sediment buildup in inlet pipe; recommend removal. No permit was found authorizing this encroachment. CVFPB will need to review crossing to determine owner. The UCIP inspection was completed with GEI staff, P. Espinoza. (H. Dunn ? GEI) 03/25/2014 Animal Burrowing activity at LS toe may undermine headwall. (W. Wylie - DWR UCIP) FIELD_STRUCT_DESC: 24-inch corrugated metal gravity drainage pipe (CMP) through the levee, 10.8 feet below the crown. Flap gate on the waterside (WS) end. Concrete headwall on the landside (LS) end. Concrete U-shaped headwall on the WS end. [Additional Reference(s): DWR Levee Log, 2002, (HLM 28.17). USACE San Joaquin O&M Manual, Unit No. 601, Part No. 1, 1967, Amended in 1978, Revised 20 June 1985, (HLM 28.17). DWR As-Built Specification No. 64-01, Sheet No. 10, 6 November 1963, (HLM 28.17)]. FS Date: 6/23/2021

View from levee crown.

LS view from crown.

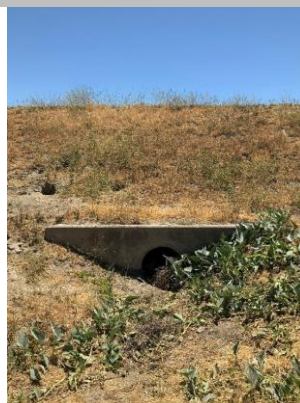
Photo 3 of 3 : UCIP_SP_2022_71073_104350.jpg

LS view from toe: concrete headwall at inlet.

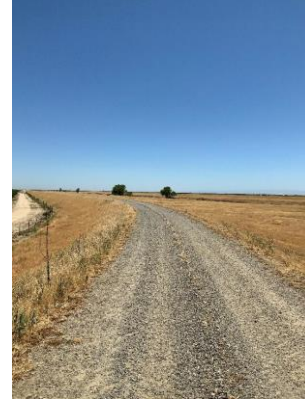
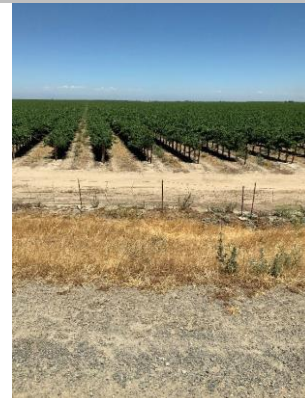
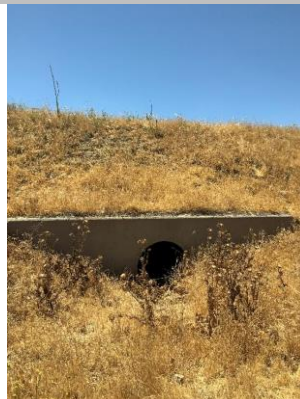
Photo 1 of 3 : UCIP_SP_2022_71074_104318.jpg

Comment Code					
Inspector Comment					
FS_ID:71074 DS_ID:19751 EP_NO: N/A Repair Type: Urgent Crossing Status: Found UCIP Comments: 06/23/2021 The record has been upgraded from No Action Needed to Urgent. DWR DMP internal inspection has found pipe integrity issues. LOF of crossing is between 5 and 6. Crossing will be monitored until funding becomes available to address the issues. Sediment build up in LS pipe inlet; recommend removal. No permit was found authorizing this encroachment. CVFPB will need to review crossing to determine owner. The UCIP inspection was completed with GEI staff, H.Dunn. (P.Espinoza ? GEI) FIELD_STRUCT_DESC: 30-inch corrugated metal gravity drainage pipe (CMP) through the levee, 9.8 feet below the crown. Flap gate on the waterside (WS) end. Concrete headwall on the landside (LS) end. Concrete U-shaped headwall on the WS end. [Additional Reference(s): DWR Levee Log, 2002, (HLM 28.69). USACE San Joaquin O&M Manual, Unit No. 601, Part No. 1, 1967, Amended in 1978, Revised 20 June 1985, (HLM 28.69). DWR As-Built Specification No. 64-01, Sheet No. 11, 6 November 1963, (HLM 28.69)]. FS Date: 6/23/2021 10:26:00 AM

View from levee crown.

LS view from crown.

LS view from toe: concrete headwall at inlet.

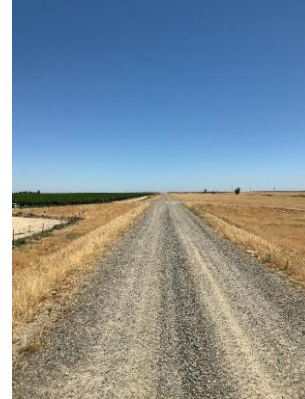
Photo 1 of 3 : UCIP_SP_2022_71075_104313.jpg

Comment Code						
Inspector Comment						
FS_ID:71075 DS_ID:19752 EP_NO: N/A Repair Type: Non-Urgent Crossing Status: Found UCIP Comments: 06/23/2021 The record remains Non-Urgent. Limited inspection of LS due to accessibility issues; barbed wire fence. No permit was found authorizing this encroachment. CVFPB will need to review crossing to determine owner. The UCIP inspection was completed with GEI staff, H.Dunn. (P.Espinoza ? GEI) 7/20/2016 same as previous inspection. Crossing has been downgraded from Urgent to Non-Urgent slide gate is on LS. Pipe is buried through WS. Need to coordinate with owner to determine permit used to authorized sleeved pipe. (O. Magana - DWR UCIP)3/27/2014 Slide gate will not close due to 24-inch PVC pipe sleeved through pipe. Also slide gate rails rusted beyond use. (W. Wylie - DWR UCIP) FIELD_STRUCT_DESC: [Rodunder Siphon] 48-inch reinforced concrete irrigation siphon pipe (RCP) through the levee, 12.1 feet below the crown. Concrete U-shaped headwall on the inlet structure on the landside (LS) end. Slide gate mounted on a concrete headwall on the LS. 36-inch corrugated metal pipe (CMP) riser unit with a slide gate on the LS, 8 feet upstream from the siphon. 24-inch pipe from this unit enters the siphon behind the inlet structure. [Additional Reference(s): DWR Levee Log, 2002, (HLM 28.95). USACE San Joaquin O&M Manual, Unit No. 601, Part No. 1, 1967, Amended in 1978, Revised 20 June 1985, (HLM 28.95). DWR As-Built Specification No. 64-01, Sheet No. 11, 6 November 1963, (HLM 28.95)]. FS Date: 6/23/2021 9:55:00 AM

View from levee crown.

View of concrete crossing through channel.

LS view from crown. Slide gate mounted to concrete headwall.

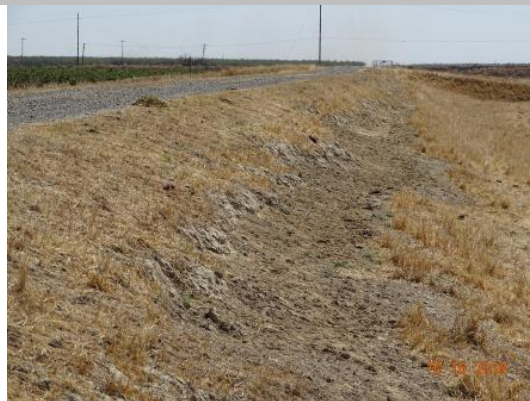
Photo 1 of 1 : SP_2022_NA0010_123_164_20220308_00053.jpg

LM Start	29.43	Rating **	M	Issue No.	164
LM End	29.56	Issue Type +	Ma	Location *	WS
Category	Earthen Levee			GPS Latitude/Longitude	
				Start	End
Item	Erosion / Livestock			37.023481 °	37.021794 °
				-120.435960 °	-120.434769 °
DWR ID	DWR_NA0010_05_f_2018_164				
Comment Code					
E4 : Repair the levee slope damaged by livestock and prevent large animal access.					
Inspector Comment					
There is slope damage on waterside from livestock traffic.

Slope damage from animal traffic. (Fall 2018)

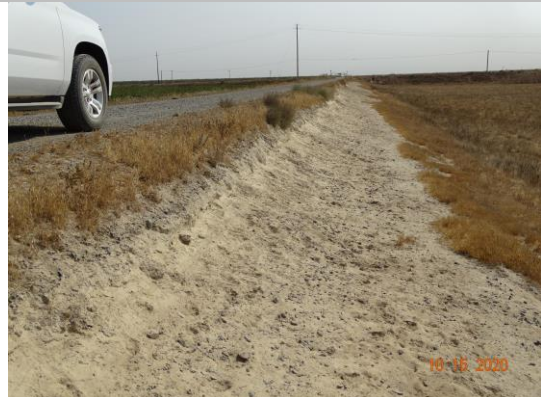
Photo 1 of 1 : SP_2022_NA0010_123_171_20220308_00058.jpg

LM Start	29.58	Rating **	U	Issue No.	171
LM End	29.80	Issue Type +	Ma	Location *	WS
Category	Earthen Levee			GPS Latitude/Longitude	
				Start	End
Item	Erosion / Livestock			37.021534 °	37.018712 °
				-120.434592 °	-120.432682 °
DWR ID	DWR_NA0010_05_s_2014_171				
Comment Code					
E4 : Repair the levee slope damaged by livestock and prevent large animal access.					
Inspector Comment					
There is waterside erosion caused by livestock.

Looking south at livestock erosion on the waterside slope. (Fall 2020)

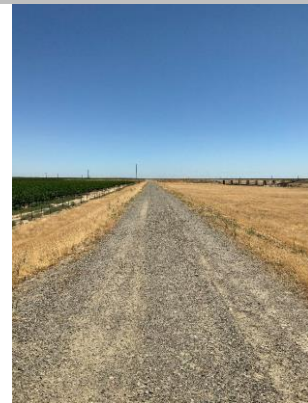
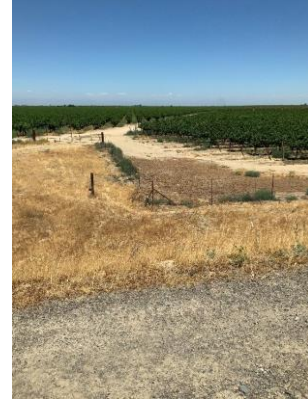
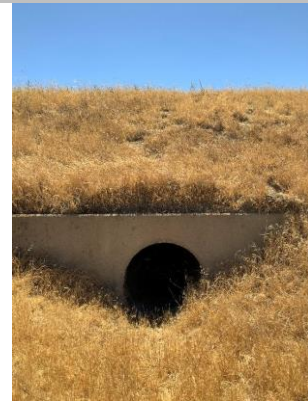
Photo 1 of 3 : UCIP_SP_2022_71076_104307.jpg

Comment Code						
Inspector Comment						
FS_ID:71076 DS_ID:19753 EP_NO: N/A Repair Type: Non-Urgent Crossing Status: Found UCIP Comments: 06/23/2021 The record remains Non-Urgent. DWR DMP internal inspection has found pipe integrity issues. LOF of crossing is between 4.1 and 5. Crossing will be monitored until funding becomes available for rehabilitation. No permit was found authorizing this encroachment. CVFPB will need to review crossing to determine owner. The UCIP inspection was completed with GEI staff, H.Dunn. (P.Espinoza ? GEI) 03/27/2014 Dense vegetation limits the inspector's visibility to identify signs of pipe failure (leaks) along the landward slope. Recommend removing vegetation along pipe alignment to conduct proper inspection of structure. Sediment buildup in pipe visible from landward side--recommend contacting owner to clear pipe. (W. Wylie - DWR UCIP) FIELD_STRUCT_DESC: 36-inch corrugated metal gravity drainage pipe (CMP) through the levee, 10.2 feet below the crown. Flap gate on the waterside (WS) end. Concrete headwall on the landside (LS) end. Concrete U-shaped headwall on the WS end. [Additional Reference(s): DWR Levee Log, 2002, (HLM 29.49). USACE San Joaquin O&M Manual, Unit No. 601, Part No. 1, 1967, Amended in 1978, Revised 20 June 1985, (HLM 29.49). DWR As-Built Specification No. 64-01, Sheet No. 12, 6 November 1963, (HLM 29.49)]. FS Date: 6/23/2021

View from levee crown.

LS view from crown.

LS view from toe: concrete headwall at inlet.

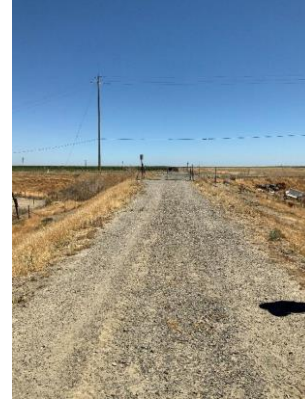
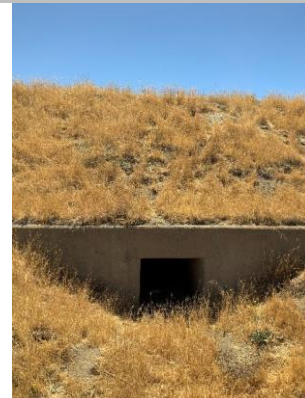
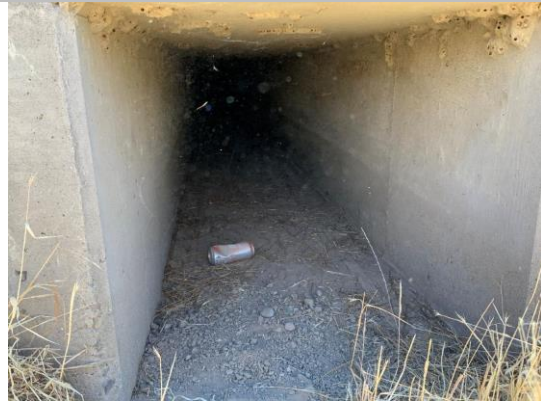
Photo 1 of 3 : UCIP_SP_2022_71087_104303.jpg

Comment Code						
Inspector Comment						
FS_ID:71087 DS_ID:19754 EP_NO: N/A Repair Type: Non-Urgent Crossing Status: Found UCIP Comments: 06/23/2021 The record remains Non-Urgent. Crossing appears to be in good condition. No permit was found authorizing this encroachment. CVFPB will need to review crossing to determine owner. The UCIP inspection was completed with GEI staff, H.Dunn. (P.Espinoza ? GEI) 03/27/2014 Dense vegetation limits the inspector's visibility to identify signs of pipe failure (leaks) along the landward slope. Recommend removing vegetation along pipe alignment to conduct proper inspection of structure. (W. Wylie - DWR UCIP) FIELD_STRUCT_DESC: 30-inch by 30-inch reinforced concrete box gravity drainage culvert (RCBC) through the levee, 12.0 feet below the crown. Flap gate on the waterside (WS) end. Concrete headwall on the landside (LS) end. Concrete U-shaped headwall on the WS end. [Additional Reference(s): DWR Levee Log, 2002, (HLM 29.72). USACE San Joaquin O&M Manual, Unit No. 601, Part No. 1, 1967, Amended in 1978, Revised 20 June 1985, (HLM 29.72). DWR As-Built Specification No. 64-42, Sheet No. 6, 13 August 1964, (HLM 29.72)]. FS Date: 6/23/2021 4:23:00 PM

View from levee crown.

LS view from toe: concrete headwall at inlet.

LS view from toe: inside of inlet.

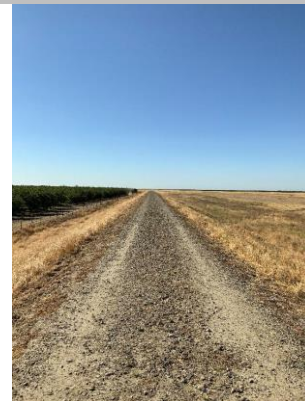
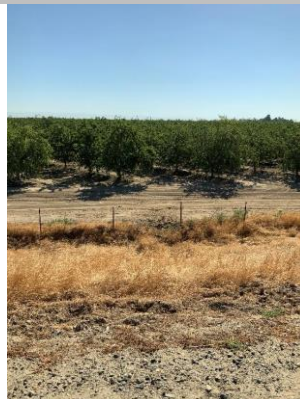
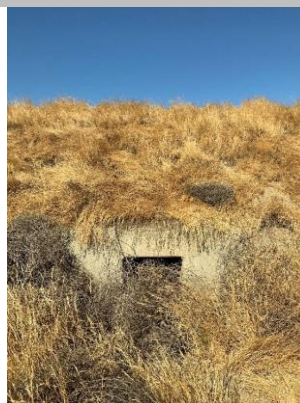
Photo 1 of 3 : UCIP_SP_2022_71078_104296.jpg

Comment Code					
Inspector Comment					
FS_ID:71078 DS_ID:19696 EP_NO: N/A Repair Type: Non-Urgent Crossing Status: Found UCIP Comments: 06/24/2021 The record remains Non-Urgent. Limited inspection of LS due to dense vegetation; recommend removal. No permit was found authorizing this encroachment. CVFPB will need to review crossing to determine owner. The UCIP inspection was completed with GEI staff, H.Dunn. (P.Espinoza ? GEI) 03/27/2014 Dense vegetation limits the inspector's visibility to identify signs of pipe failure (leaks) along the landward slope. Recommend removing vegetation along pipe alignment to conduct proper inspection of structure. (W. Wylie - DWR UCIP) FIELD_STRUCT_DESC: 30-inch by 30-inch reinforced concrete box gravity drainage culvert (RCBC) through the levee, 13.1 feet below the crown. Flap gate on the waterside (WS) end. Concrete headwall on the landside (LS) end. Concrete U-shaped headwall on the WS end. [Additional Reference(s): DWR Levee Log, 2002, (HLM 30.04). USACE San Joaquin O&M Manual, Unit No. 601, Part No. 1, 1967, Amended in 1978, Revised 20 June 1985, (HLM 30.04). DWR As-Built Specification No. 64-42, Sheet No. 6, 13 August 1964, (HLM 30.04)]. FS Date: 6/24/2021

View from levee crown.

LS view from crown.

LS view from toe: concrete headwall at inlet.

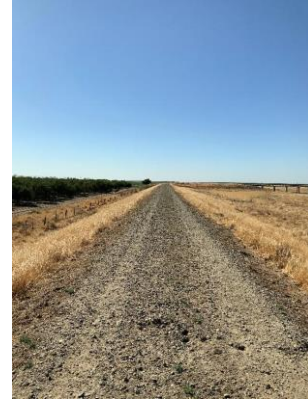
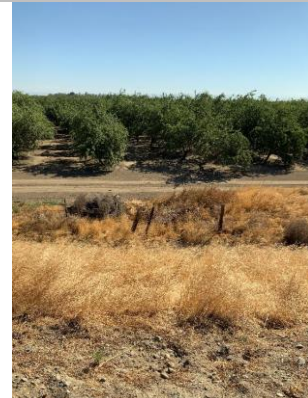
Photo 1 of 3 : UCIP_SP_2022_71079_104289.jpg

Comment Code					
Inspector Comment					
FS_ID:71079 DS_ID:19697 EP_NO: N/A Repair Type: Non-Urgent Crossing Status: Found UCIP Comments: 06/24/2021 The record remains Non-Urgent. Crossing appears to be in good condition. No permit was found authorizing this encroachment. CVFPB will need to review crossing to determine owner. The UCIP inspection was completed with GEI staff, H.Dunn. (P.Espinoza ? GEI) 03/27/2014 Some debris buildup at LS toe. Dense vegetation limits the inspector's visibility to identify signs of pipe failure (leaks) along the landward slope. Recommend removing vegetation along pipe alignment to conduct proper inspection of structure. (W. Wylie - DWR UCIP) FIELD_STRUCT_DESC: 30-inch by 30-inch reinforced concrete box gravity drainage culvert (RCBC) through the levee, 13.3 feet below the crown. Flap gate on the waterside (WS) end. Concrete headwall on the landside (LS) end. Concrete U-shaped headwall on the WS end. [Additional Reference(s): DWR Levee Log, 2002, (HLM 30.97). USACE San Joaquin O&M Manual, Unit No. 601, Part No. 1, 1967, Amended in 1978, Revised 20 June 1985, (HLM 30.96). DWR As-Built Specification No. 64-42, Sheet No. 7, 13 August 1964, (HLM 30.96)]. FS Date: 6/24/2021 3:36:00 PM

Levee crown.

LS view from crown.

LS view from toe: concrete headwall at inlet.

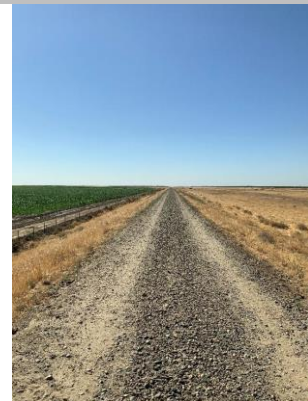
Photo 1 of 3 : UCIP_SP_2022_71080_104282.jpg

FS_ID:71080
DS_ID:19698
EP_NO: N/A
Repair Type: Non-Urgent
Crossing Status: Found
UCIP Comments: 06/24/2021 The record remains Non-Urgent. Some tumbleweed buildup over WS flapgate and LS inlet, recommend removal. No permit was found authorizing this encroachment. CVFPB will need to review crossing to determine owner. The UCIP inspection was completed with GEI staff, H.Dunn. (P.Espinoza ? GEI)

03/27/2014 Excess vegetation buildup at inlet on LS toe. Dense vegetation limits the inspector's visibility to identify signs of pipe failure (leaks) along the landward slope. Recommend removing vegetation along pipe alignment to conduct proper inspection of structure. (W. Wylie - DWR UCIP)

View from levee crown.

View of LS from crown.

LS view from toe: concrete headwall at inlet.

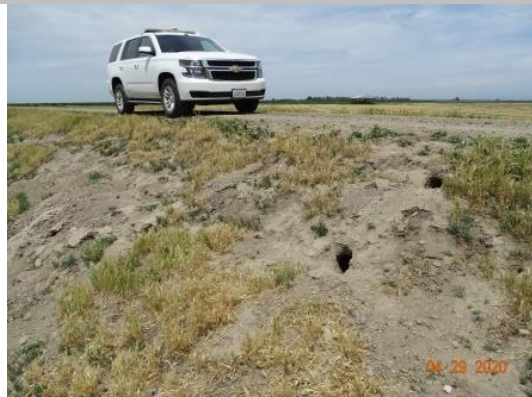
Photo 1 of 1 : SP_2022_NA0010_123_230_20220308_00064.jpg

LM Start	31.66	Rating **	U	Issue No.	230
LM End	31.66	Issue Type +	Ma	Location *	WS
Category	Earthen Levee			GPS Latitude/Longitude	
				Start	End
Item	Animal Control			36.997828 °	36.997828 °
				-120.411920 °	-120.411920 °
DWR ID	DWR_NA0010_05_s_2020_230				
Comment Code					
A3 : No rodents visible, but rodent burrows visible; need to backfill and compact or grout burrows.					
Inspector Comment					
Several rodent burrows in the waterside slope and shoulder.

Rodent burrows in the waterside slope. (Spring 2020)

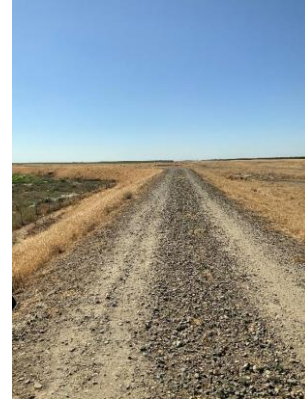
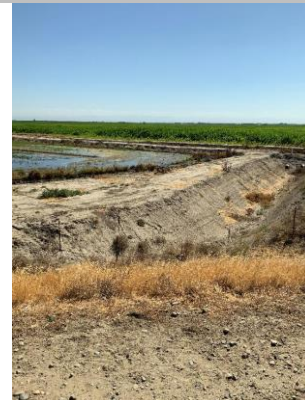
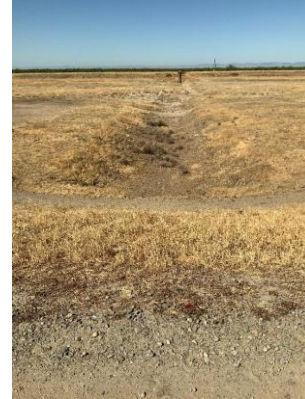
Comment Code						
Inspector Comment						
FS_ID:71081 DS_ID:19699 EP_NO: N/A Repair Type: Non-Urgent Crossing Status: Found UCIP Comments: 06/24/2021 The record has been upgraded from No Action Needed to Non-Urgent. Limited inspection of LS due to dense vegetation; recommend removal. Wooden planks propping flapgate on WS open; recommend removal before flood season. No permit was found authorizing this encroachment. CVFPB will need to review crossing to determine owner. The UCIP inspection was completed with GEI staff, H.Dunn. (P.Espinoza ? GEI) FIELD_STRUCT_DESC: 48-inch by 36-inch reinforced concrete box gravity drainage culvert (RCBC) through the levee, 14.5 feet below the crown. Flap gate on the waterside (WS) end. Concrete U-shaped headwall on each end. [Additional Reference(s): DWR Levee Log, 2002, (HLM 31.64). USACE San Joaquin O&M Manual, Unit No. 601, Part No. 1, 1967, Amended in 1978, Revised 20 June 1985, (HLM 31.64). DWR As-Built Specification No. 64-42, Sheet No. 8, 13 August 1964, (HLM 31.64)]. FS Date: 6/24/2021 2:15:00 PM

View from levee crown.

LS view from crown.

WS view from crown.

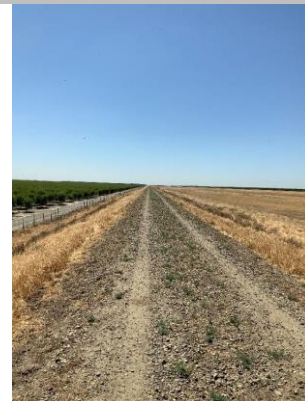
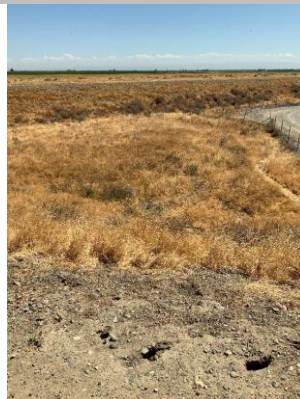
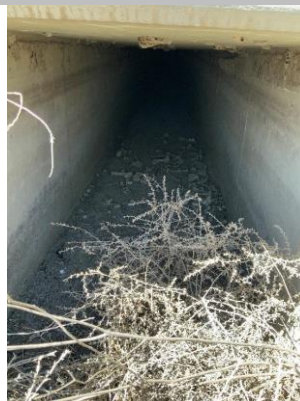
FS_ID:71082
 DS_ID:19700
 EP_NO: N/A
 Repair Type: Non-Urgent
 Crossing Status: Found
 UCIP Comments: 06/23/2021 The record remains Non-Urgent. Some tumbleweed buildup at LS inlet and WS flapgate, recommend removal. No permit was found authorizing this encroachment. CVFPB will need to review crossing to determine owner. The UCIP inspection was completed with GEI staff, H.Dunn. (P.Espinoza ? GEI) 04/01/2014
 Dense vegetation limits the inspector's visibility to identify signs of pipe failure (leaks) along the landward slope. Recommend removing vegetation along pipe alignment to conduct proper inspection of structure. (W. Wylie - DWR UCIP)
 FIELD_STRUCT_DESC: 30-inch by 30-inch reinforced concrete box gravity drainage culvert (RCBC) through the levee, 13.0 feet below the crown. Flap gate on the waterside (WS) end. Concrete headwall on the landside (LS) end with flashboard attachment. Concrete U-shaped headwall on the WS end. [Additional Reference(s): DWR Levee Log, 2002, (HLM 31.69). USACE San Joaquin O&M Manual, Unit No. 601, Part No. 1, 1967, Amended in 1978, Revised 20 June 1985, (HLM 31.71). DWR As-Built Specification No. 64-42, Sheet No. 8, 13 August 1964, (HLM 31.71)].

View from levee crown.

LS view from crown.

LS view: inside view of inlet.

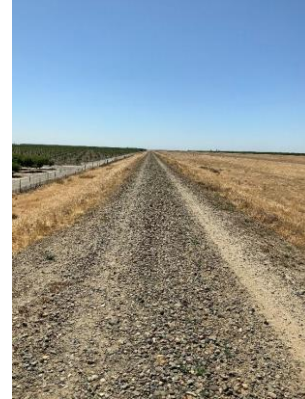
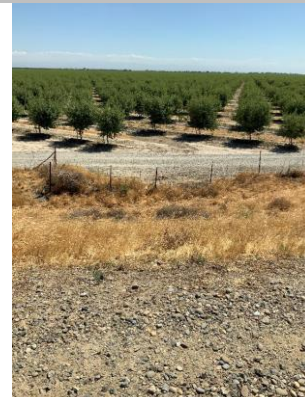
Comment Code					
Inspector Comment					
FS_ID:71083 DS_ID:19701 EP_NO: N/A Repair Type: Non-Urgent Crossing Status: Found UCIP Comments: 06/23/2021 The record remains Non-Urgent. Limited inspection of LS inlet due to dense vegetation; recommend removal. No permit was found authorizing this encroachment. CVFPB will need to review crossing to determine owner. The UCIP inspection was completed with GEI staff, H.Dunn. (P.Espinoza ? GEI) 04/01/2014 Some silt buildup inside culvert. (W. Wylie - DWR UCIP) FIELD_STRUCT_DESC: 30-inch by 30-inch reinforced concrete box gravity drainage culvert (RCBC) through the levee, 14.2 feet below the crown. Flap gate on the waterside (WS) end. Concrete headwall on the landside (LS) end with flashboard attachment. Concrete U-shaped headwall on the WS end. [Additional Reference(s): DWR Levee Log, 2002, (HLM 32.22). USACE San Joaquin O&M Manual, Unit No. 601, Part No. 1, 1967, Amended in 1978, Revised 20 June 1985, (HLM 32.22). DWR As-Built Specification No. 64-42, Sheet No. 8, 13 August 1964, (HLM 32.22)]. FS Date: 6/23/2021 1:18:00 PM

View from levee crown.

LS view from crown.

LS view from toe: concrete headwall at inlet.

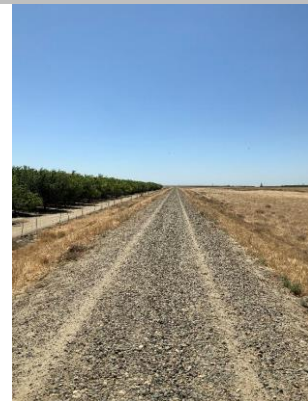
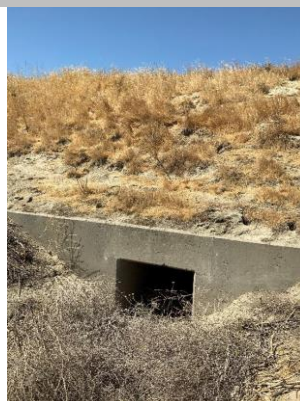
UCIP Comments: 06/23/2021 The record remains Non-Urgent. Some tumbleweed buildup over WS flapgate and LS inlet, recommend removal. No permit was found authorizing this encroachment. CVFPB will need to review crossing to determine owner. The UCIP inspection was completed with GEI staff, H.Dunn. (P.Espinoza ? GEI)

04/01/2014 Dense vegetation limits the inspector's visibility to identify signs of pipe failure (leaks) along the landward slope. Recommend removing vegetation along pipe alignment to conduct proper inspection of structure. Debris buildup blocking landward headwall--recommend contacting owner to clear debris. (W. Wylie - DWR UCIP)

View from levee crown.

LS view from crown.

LS view from toe: concrete headwall at inlet.

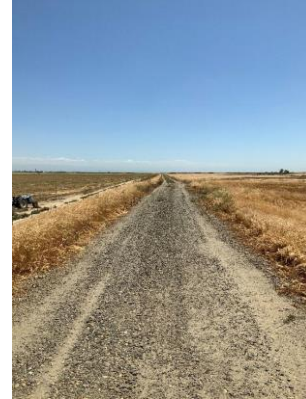
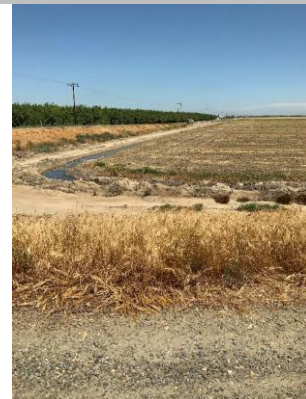
Comment Code					
Inspector Comment					
FS_ID:71085 DS_ID:19703 EP_NO: N/A Repair Type: Non-Urgent Crossing Status: Found UCIP Comments: 06/24/2021 The record remains Non-Urgent. Limited inspection of LS and WS due to dense vegetation; recommend removal. No permit was found authorizing this encroachment. CVFPB will need to review crossing to determine owner. The UCIP inspection was completed with GEI staff, H.Dunn. (P.Espinoza ? GEI) 04/01/2014 Dense vegetation limits the inspector's visibility to identify signs of pipe failure (leaks) along the slopes. Recommend removing vegetation along pipe alignment to conduct proper inspection of structure. (W. Wylie - DWR UCIP) FIELD_STRUCT_DESC: 30-inch by 30-inch reinforced concrete box gravity drainage culvert (RCBC) through the levee, 13.9 feet below the crown. Flap gate on the waterside (WS) end. Concrete headwall on the landside (LS) end. Concrete U-shaped headwall on the WS end. [Additional Reference(s): DWR Levee Log, 2002, (HLM 33.72). USACE San Joaquin O&M Manual, Unit No. 601, Part No. 1, 1967, Amended in 1978, Revised 20 June 1985, (HLM 33.72). DWR As-Built Specification No. 64-42, Sheet No. 9, 13 August 1964, (HLM 33.72)]. FS Date: 6/24/2021 12:30:00 PM

View from levee crown.

LS view from crown.

LS view from toe: concrete headwall and inlet.

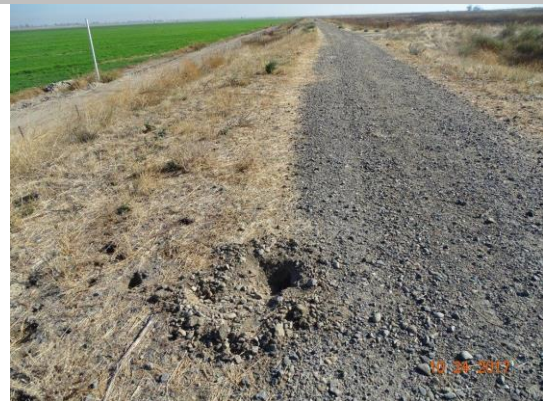
Photo 1 of 1 : SP_2022_NA0010_123_130_20220308_00030.jpg

LM Start	33.82	Rating **	M	Issue No.	130
LM End	33.82	Issue Type +	Ma	Location *	LS
Category	Earthen Levee			GPS Latitude/Longitude	
				Start	End
Item	Animal Control			36.976849 °	36.976849 °
				-120.382393 °	-120.382393 °
DWR ID	DWR_NA0010_05_f _ 2017_130				
Comment Code					
A3 : No rodents visible, but rodent burrows visible; need to backfill and compact or grout burrows.					
Inspector Comment

Looking east at the landside shoulder.

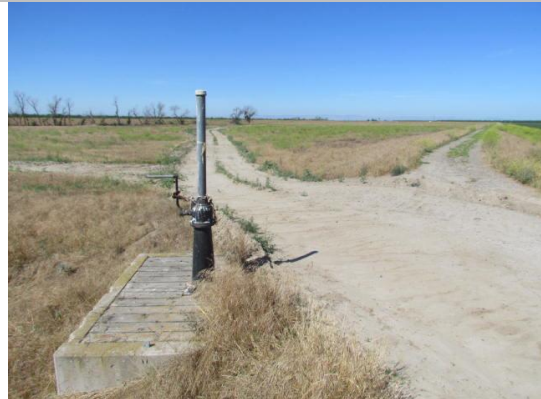
Photo 1 of 1 : SP_2022_NA0010_123_11_20220308_00008.jpg

LM Start	34.61	Rating **	M	Issue No.	11
LM End	34.61	Issue Type +	En	Location *	WS
Category	Earthen Levee			GPS Latitude/Longitude	
				Start	End
Item	Encroachments			36.978523 °	36.978523 °
				-120.368520 °	-120.368520 °
DWR ID	DWR_NA0010_05_s_2012_11				
Comment Code					
RA : Ramp					
Inspector Comment					
There is an unauthorized ramp on waterside slope. Landowner cut unauthorized ramp on waterside slope and levee crown.

Looking west at ramp on waterward slope.

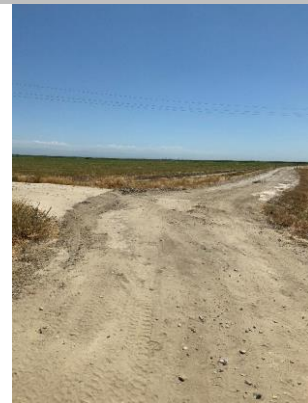
Comment Code					
Inspector Comment					
FS_ID:71086 DS_ID:19755 EP_NO: N/A Repair Type: Non-Urgent Crossing Status: Found UCIP Comments: 06/24/2021 The record remains Non-Urgent. Limited inspection of WS and LS due to dense vegetation, recommend removal. No permit was found authorizing this encroachment. CVFPB will need to review crossing to determine owner. The UCIP inspection was completed with GEI staff, H.Dunn. (P.Espinoza ? GEI) 04/01/2014 Dense vegetation limits the inspector's visibility to identify signs of pipe failure (leaks) along the landward slope. Recommend removing vegetation along pipe alignment to conduct proper inspection of structure. Debris buildup visible on waterward headwall--recommend contacting owner to clear pipe. (W. Wylie - DWR UCIP) FIELD_STRUCT_DESC: [Chowchilla Canal Irrigation Structure] 36-inch by 36-inch reinforced concrete box gravity irrigation culvert (RCBC) through the levee, 9.7 feet below the crown. Slide gate in a 56-inch by 91-inch concrete riser unit on the waterside (WS) slope. Concrete U-shaped headwall on each end. Landside channel cobble revetted for 8 feet. [Additional Reference(s): DWR Levee Log, 2002, (HLM 34.51). USACE San Joaquin O&M Manual, Unit No. 601, Part No. 1, 1967, Amended in 1978, Revised 20 June 1985, (HLM 34.51). DWR As-Built Specification No. 64-42, Sheet No. 10, 13 August 1964, (HLM 34.51)]. FS Date: 6/24/2021 11:58:00 AM

View of levee crown.

LS view from crown.

LS view from toe: concrete headwall and inlet.

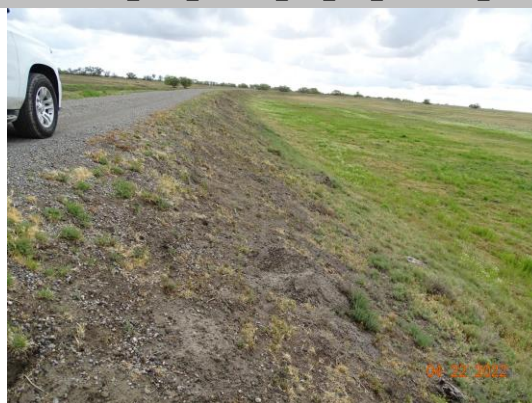
Photo 1 of 1 : SP_2022_NA0010_124_147_20220425_00228.jpg

LM Start	0.14	Rating **	M	Issue No.	147
LM End	0.14	Issue Type +	Ma	Location *	LS
Category	Earthen Levee			GPS Latitude/Longitude	
				Start	End
Item	Animal Control			37.275637 °	37.275637 °
				-120.823438 °	-120.823438 °
DWR ID	DWR_NA0010_06_s_2022_147				
Comment Code					
A3 : No rodents visible, but rodent burrows visible; need to backfill and compact or grout burrows.					
Inspector Comment

View of rodent burrows on the landside slope. (Spring 2022)

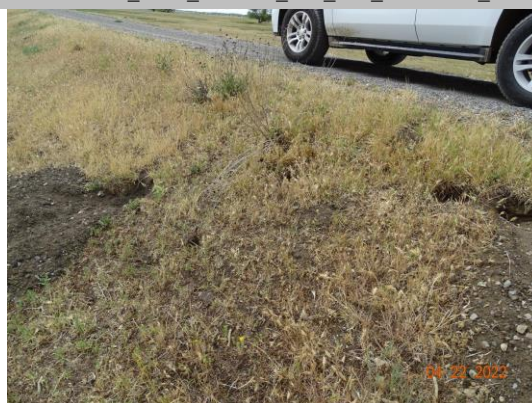
Photo 1 of 1 : SP_2022_NA0010_124_148_20220425_00229.jpg

LM Start	0.43	Rating **	M	Issue No.	148
LM End	0.43	Issue Type +	Ma	Location *	WS
Category	Earthen Levee			GPS Latitude/Longitude	
				Start	End
Item	Animal Control			37.273651 °	37.273651 °
				-120.818813 °	-120.818813 °
DWR ID	DWR_NA0010_06_s_2022_148				
Comment Code					
A1 : Exterminate rodents and backfill and compact or grout burrows.					
Inspector Comment

View of active rodent burrows on the waterside slope. (Spring 2022)

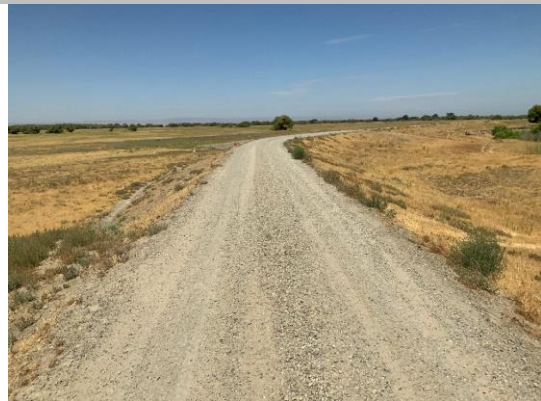
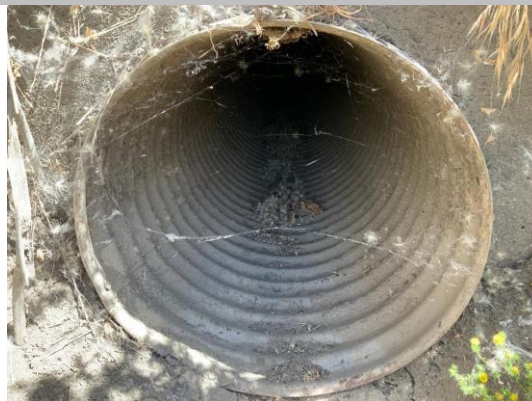
Comment Code						
Inspector Comment						
FS_ID:71161 DS_ID:19815 EP_NO: N/A Repair Type: Non-Urgent Crossing Status: Found UCIP Comments: 07/27/2021 The record remains Non-Urgent. Crossing appears to be in good condition and there is no longer sediment buildup. No permit was found authorizing this encroachment. CVFPB will need to review crossing to determine owner. The UCIP inspection was completed with GEI staff, P. Espinoza. (H. Dunn ? GEI) 04/18/2014 Need to contact owner. Sediment buildup on landward side. Recommend removing sediment buildup on landward toe. (O. Magana - DWR UCIP) FIELD_STRUCT_DESC: 24-inch corrugated metal irrigation discharge pipe (CMP) through the levee, 7.2 feet below the crown. Pump on a concrete structure in the channel. Slide gate in a 36-inch CMP riser unit on the waterside (WS) slope. Concrete headwall on each end. [Additional Reference(s): DWR Levee Log, 2002, (HLM 0.74). USACE San Joaquin O&M Manual, Unit No. 601, Part No. 1, 1967, Amended in 1978, Revised 20 June 1985, (HLM 0.74). DWR As-Built Specification No. 61-01, Sheet No. 45, 7 March 1961, (HLM 0.74)]. FS Date: 7/27/2021

Levee crown.

LS view: Toe from crown.

LS view: Closeup of pipe outlet at toe.

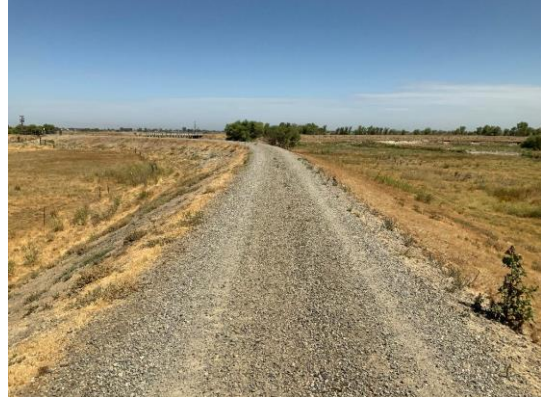
Photo 1 of 3 : UCIP_SP_2022_71092_102876.jpg

Comment Code						
Inspector Comment						
FS_ID:71092 DS_ID:19816 EP_NO: N/A Repair Type: Non-Urgent Crossing Status: Found UCIP Comments: 07/27/2021 The record remains Non-Urgent. LS pipe inlet is blocked by barbed wire, limited access and inspection. No permit was found authorizing this encroachment. CVFPB will need to review crossing to determine owner. The UCIP inspection was completed with GEI staff, P. Espinoza. (H. Dunn ? GEI) 04/18/2014 Landward side blocked--need to contact owner to determine status of crossing. (O. Magana - DWR UCIP) FIELD_STRUCT_DESC: 24-inch corrugated metal gravity drainage pipe (CMP) through the levee, 16.2 feet below the crown. Flap gate on the waterside (WS) end. Concrete U-shaped headwall on each end. [Additional Reference(s): DWR Levee Log, 2002, (HLM 0.86). USACE San Joaquin O&M Manual, Unit No. 601, Part No. 1, 1967, Amended in 1978, Revised 20 June 1985, (HLM 0.86). DWR As-Built Specification No. 61-01, Sheet No. 45, 7 March 1961, (HLM 0.86)]. FS Date: 7/27/2021

Levee crown.

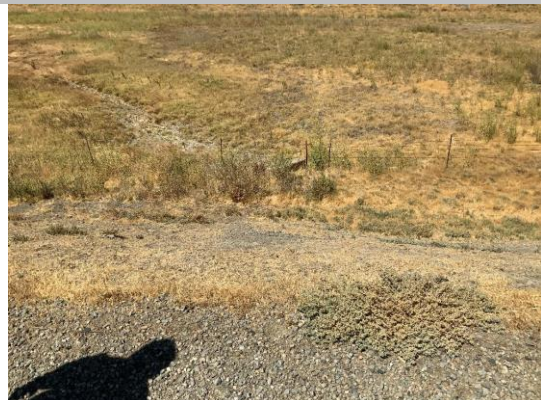
Photo 2 of 3 : UCIP_SP_2022_71092_102877.jpg

LS view: Toe from crown.

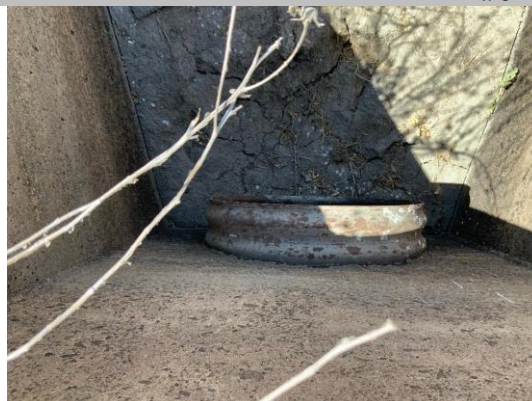
Photo 3 of 3 : UCIP_SP_2022_71092_102879.jpg

LS view: Top view of pipe inlet at toe.

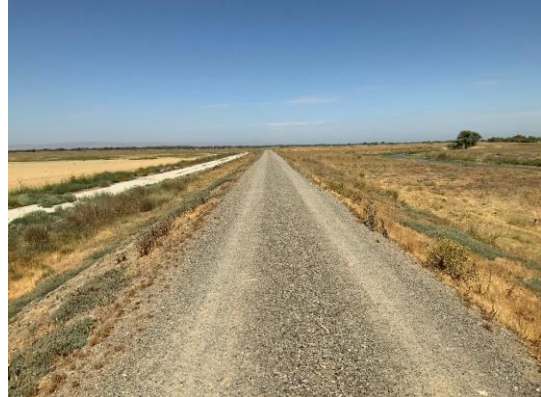
Photo 1 of 3 : UCIP_SP_2022_71093_102901.jpg

Comment Code					
Inspector Comment					
FS_ID:71093 DS_ID:19817 EP_NO: N/A Repair Type: Non-Urgent Crossing Status: Found UCIP Comments: 07/27/2021 The record remains Non-Urgent. LS pipe inlet inaccessible due to barbed wire and not visible due to dense vegetation, limited inspection and recommend removing vegetation. No permit was found authorizing this encroachment. CVFPB will need to review crossing to determine owner. The UCIP inspection was completed with GEI staff, P. Espinoza. (H. Dunn ? GEI) 04/18/2014 No access was available to landward side due to fence. Recommend removing some of the vegetation on waterward toe. (O. Magana - DWR UCIP) FIELD_STRUCT_DESC: 24-inch corrugated metal gravity drainage pipe (CMP) through the levee, 13.5 feet below the crown. Flap gate on the waterside (WS) end. Concrete headwall on each end. [Additional Reference(s): DWR Levee Log, 2002, (HLM 1.96). USACE San Joaquin O&M Manual, Unit No. 601, Part No. 1, 1967, Amended in 1978, Revised 20 June 1985, (HLM 1.95). DWR As-Built Specification No. 61-01, Sheet No. 46, 7 March 1961, (HLM 1.95)]. FS Date: 7/27/2021

Levee crown.

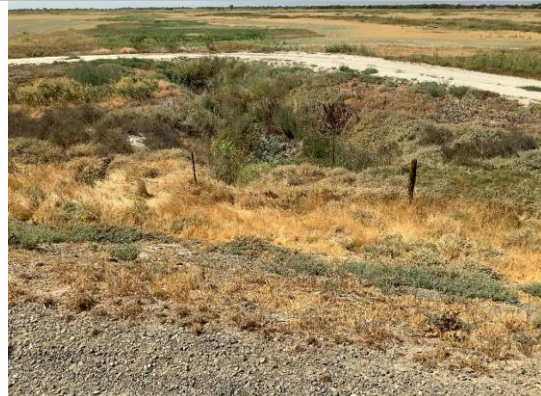
Photo 2 of 3 : UCIP_SP_2022_71093_102902.jpg

LS view: Toe from crown.

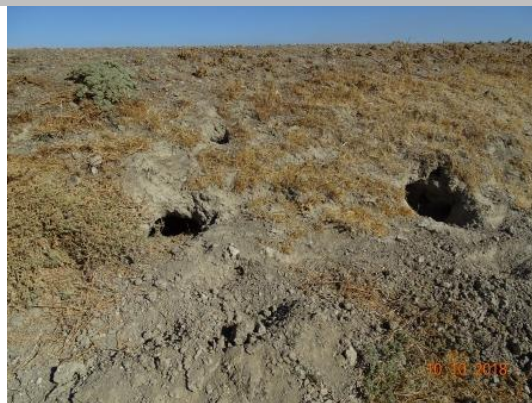
Photo 1 of 1 : SP_2022_NA0010_124_92_20220308_00026.jpg

LM Start	2.42	Rating **	U	Issue No.	92
LM End	2.42	Issue Type +	Ma	Location *	LS
Category	Earthen Levee			GPS Latitude/Longitude	
				Start	End
Item	Animal Control			37.254519 °	37.254519 °
				-120.795141 °	-120.795141 °
DWR ID	DWR_NA0010_06_f_2018_92				
Comment Code					
A3 : No rodents visible, but rodent burrows visible; need to backfill and compact or grout burrows.					
Inspector Comment

View of large rodent holes in landside slope. (Fall 2018)

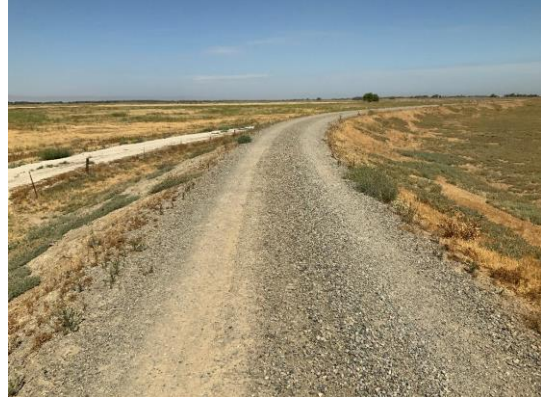
Photo 1 of 3 : UCIP_SP_2022_71094_102913.jpg

FS_ID:71094
DS_ID:19818
EP_NO: N/A
Repair Type: Non-Urgent
Crossing Status: Found
UCIP Comments: 07/27/2021 The record remains Non-Urgent. DWR DMP internal inspection has found pipe integrity issues. LOF of crossing is between 4.1 and 5. Crossing will be monitored until funding becomes available for rehabilitation. No permit was found authorizing this encroachment. CVFPB will need to review crossing to determine owner. The UCIP inspection was completed with GEI staff, P. Espinoza. (H. Dunn ? GEI) 04/18/2014 Need to contact owner. Sediment buildup in pipe visible on landward side. (O. Magana - DWR UCIP)
FIELD_STRUCT_DESC: 36-inch corrugated metal gravity drainage pipe (CMP) through the levee, 6.9 feet below the crown. Slide gate in a 48-inch CMP riser unit on the waterside (WS) slope. Concrete headwall on each end. [Additional Reference(s): DWR Levee Log, 2002, (HLM 2.61). USACE San Joaquin O&M Manual, Unit No. 601, Part No. 1, 1967, Amended in 1978, Revised 20 June 1985, (HLM 2.61). DWR As-Built Specification No. 61-01, Sheet No. 46, 7 March 1961, (HLM 2.61)].

Levee crown.

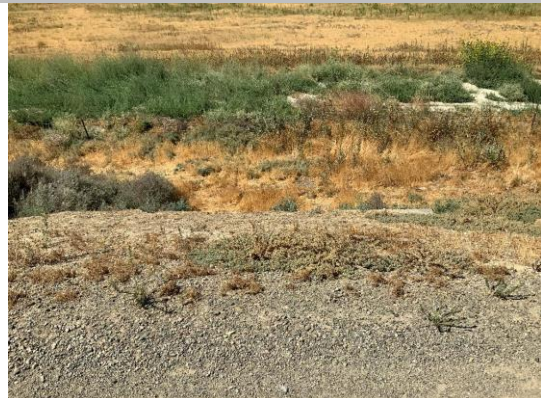
Photo 2 of 3 : UCIP_SP_2022_71094_102914.jpg

LS view: Headwall visible at toe from crown.

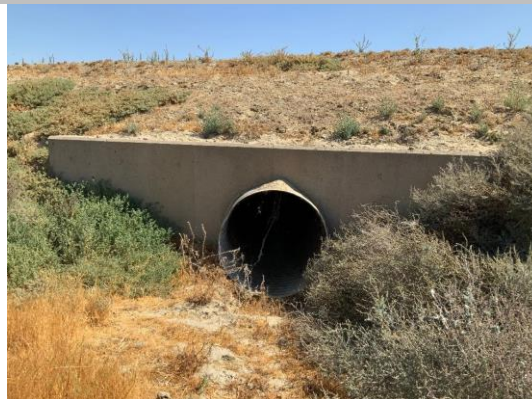
Photo 3 of 3 : UCIP_SP_2022_71094_102915.jpg

LS view: Headwall and slope from toe.

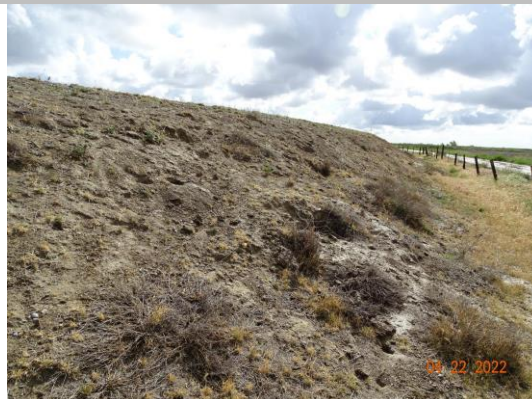
Photo 1 of 1 : SP_2022_NA0010_124_76_20220425_00231.jpg

LM Start	2.54	Rating **	M	Issue No.	76
LM End	2.54	Issue Type +	Ma	Location *	LS
Category	Earthen Levee			GPS Latitude/Longitude	
				Start	End
Item	Animal Control			37.252874 °	37.252874 °
				-120.794192 °	-120.794192 °
DWR ID	DWR_NA0010_06_f _ 2016_76				
Comment Code					
A3 : No rodents visible, but rodent burrows visible; need to backfill and compact or grout burrows.					
Inspector Comment					
There are several rodent burrows in the landside slope at this location.

View of rodent holes on the landside slope looking upstream. (Spring 2022)

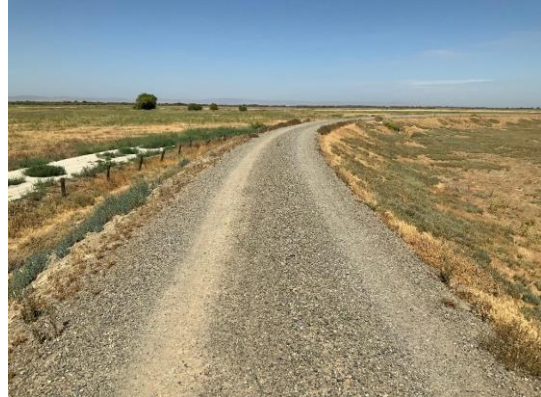
Photo 1 of 3 : UCIP_SP_2022_71095_102919.jpg

Comment Code						
Inspector Comment						
FS_ID:71095 DS_ID:19819 EP_NO: N/A Repair Type: Non-Urgent Crossing Status: Found UCIP Comments: 07/27/2021 The record remains Non-Urgent. DWR DMP internal inspection has found pipe integrity issues. LOF of crossing is between 4.1 and 5. Crossing will be monitored until funding becomes available for rehabilitation. Dense vegetation covering LS pipe inlet, limited inspection and recommend removal. No permit was found authorizing this encroachment. CVFPB will need to review crossing to determine owner. The UCIP inspection was completed with GEI staff, P. Espinoza. (H. Dunn ? GEI) 04/18/2014 Dense vegetation limits the inspector's visibility to identify signs of pipe condition on landward toe--headwall blocked by dense vegetation. Recommend removing vegetation from landward toe. (O. Magana - DWR UCIP) FIELD_STRUCT_DESC: 24-inch corrugated metal gravity drainage pipe (CMP) through the levee, 9.2 feet below the crown. Flap gate on the waterside (WS) end. Concrete headwall on each end. [Additional Reference(s): DWR Levee Log, 2002, (HLM 2.65). USACE San Joaquin O&M Manual, Unit No. 601, Part No. 1, 1967, Amended in 1978, Revised 20 June 1985, (HLM 2.65). DWR As-Built Specification No. 61-01, Sheet No. 46, 7 March 1961, (HLM 2.65)]. FS Date: 7/27/2021

Levee crown.

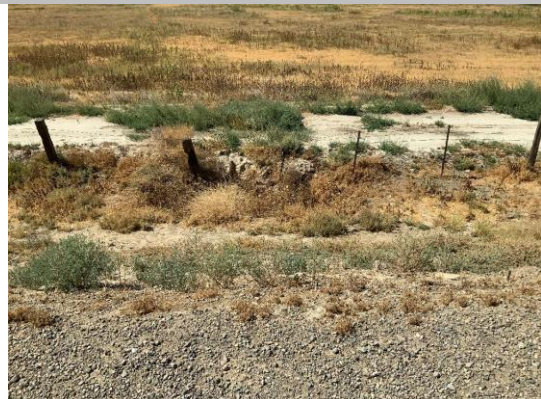
Photo 2 of 3 : UCIP_SP_2022_71095_102920.jpg

LS view: Toe from crown.

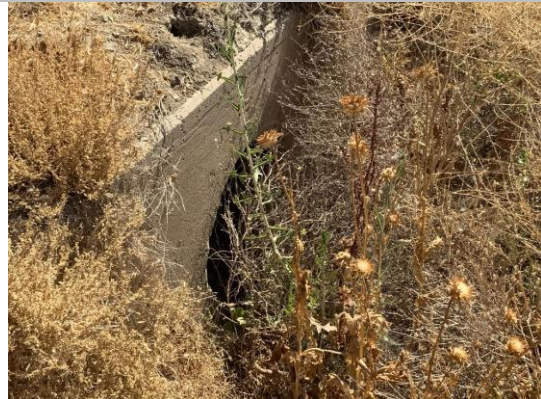
Photo 3 of 3 : UCIP_SP_2022_71095_102921.jpg

LS view: Closeup of pipe inlet at toe with dense vegetation.

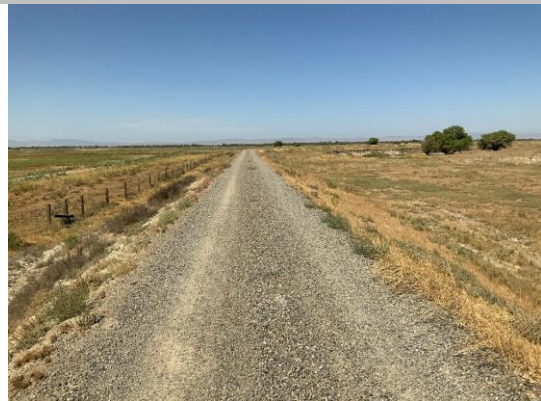
Photo 1 of 3 : UCIP_SP_2022_71096_102928.jpg

FS_ID:71096
DS_ID:19820
EP_NO: N/A
Repair Type: Urgent
Crossing Status: Found
UCIP Comments: 07/27/2021 The record has been upgraded from Non-Urgent to Urgent. DWR DMP internal inspection has found pipe integrity issues. LOF of crossing is greater than or equal to 5 and less than 6. Crossing will be monitored until funding becomes available to address the issues. Dense vegetation covering LS pipe inlet, limited inspection and recommend removal of vegetation. Some minor erosion under WS concrete pad, less than a foot in length. No permit was found authorizing this encroachment. CVFPB will need to review crossing to determine owner. The UCIP inspection was completed with GEI staff, P. Espinoza. (H. Dunn ? GEI) 04/18/2014 Dense vegetation limits the inspector's visibility to identify signs of pipe condition on landward toe-headwall blocked by dense vegetation. Recommend removing vegetation from landward toe. (O. Magana - DWR UCIP)

Levee crown.

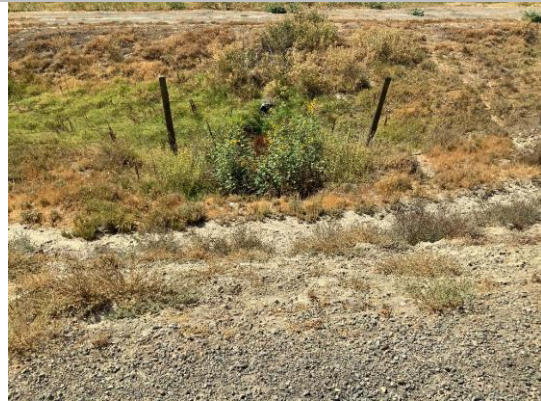
Photo 2 of 3 : UCIP_SP_2022_71096_102929.jpg

LS view: Toe from crown.

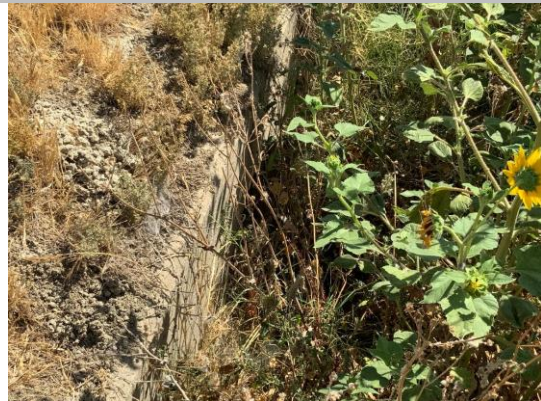
Photo 3 of 3 : UCIP_SP_2022_71096_102930.jpg

LS view: Closeup of pipe inlet at toe covered with vegetation.

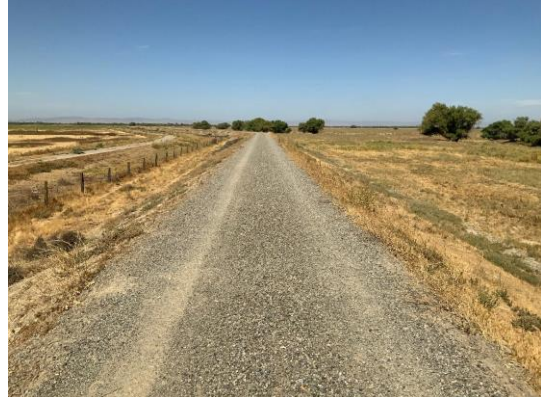
Photo 1 of 3 : UCIP_SP_2022_71097_102944.jpg

Comment Code						
Inspector Comment						
FS_ID:71097 DS_ID:19821 EP_NO: N/A Repair Type: Non-Urgent Crossing Status: Found UCIP Comments: 07/27/2021 The record remains Non-Urgent. Limited inspection due to sediment and debris buildup inside LS pipe inlet, recommend removal. Sediment buildup keeping WS flapgate open, recommend removal. No permit was found authorizing this encroachment. CVFPB will need to review crossing to determine owner. The UCIP inspection was completed with GEI staff, P. Espinoza. (H. Dunn ? GEI) 04/18/2014 Dense vegetation limits the inspector's visibility to identify signs of pipe condition on landward toe--headwall blocked by dense vegetation. Recommend removing vegetation from landward toe. (O. Magana - DWR UCIP) FIELD_STRUCT_DESC: 24-inch corrugated metal gravity drainage pipe (CMP) through the levee, 11.2 feet below the crown. Flap gate on the waterside (WS) end. Concrete headwall on each end. [Additional Reference(s): DWR Levee Log, 2002, (HLM 3.09). USACE San Joaquin O&M Manual, Unit No. 601, Part No. 1, 1967, Amended in 1978, Revised 20 June 1985, (HLM 3.09). DWR As-Built Specification No. 61-01, Sheet No. 47, 7 March 1961, (HLM 3.09)]. FS Date: 7/27/2021

Levee crown.

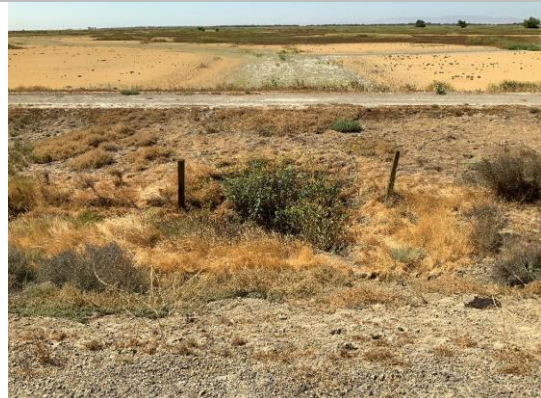
Photo 2 of 3 : UCIP_SP_2022_71097_102945.jpg

LS view: Toe from crown.

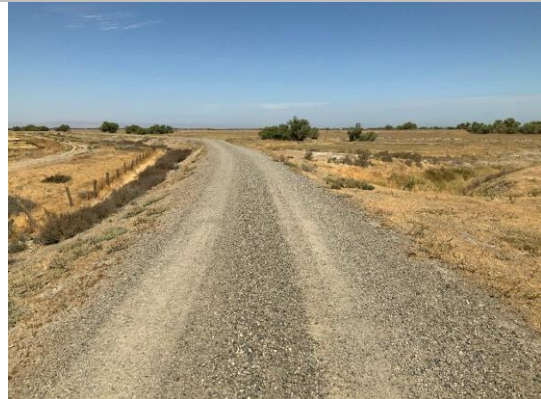
Photo 1 of 3 : UCIP_SP_2022_71098_102952.jpg

FS_ID:71098
DS_ID:19822
EP_NO: N/A
Repair Type: Non-Urgent
Crossing Status: Found
UCIP Comments: 07/27/2021 The record remains Non-Urgent. DWR DMP internal inspection has found pipe integrity issues. LOF of crossing is between 4.1 and 5. Crossing will be monitored until funding becomes available for rehabilitation. There is minor separation of the CMP and concrete headwall on the LS toe. No permit was found authorizing this encroachment. CVFPB will need to review crossing to determine owner. The UCIP inspection was completed with GEI staff, P. Espinoza. (H. Dunn ? GEI) 04/18/2014 Dense vegetation limits the inspector's visibility to identify signs of pipe condition on waterward slope and landward toe (headwall blocked by dense vegetation). Recommend removing vegetation from landward toe. (O. Magana - DWR UCIP)
FIELD_STRUCT_DESC: 24-inch corrugated metal gravity drainage pipe (CMP) through the levee, 10.4 feet below the crown. Flap gate on the waterside (WS) end. Concrete headwall on each end. [Additional Reference(s): DWR Levee Log, 2002, (HLM 3.29). USACE San Joaquin O&M Manual, Unit No. 601, Part No. 1, 1967, Amended in 1978, Revised 20 June 1985, (HLM 3.29). DWR As-Built Specification No. 61-01, Sheet No. 47, 7 March 1961, (HLM 3.29)].

Levee crown.

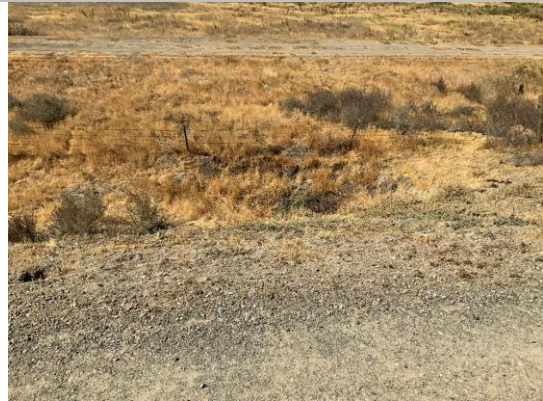
Photo 2 of 3 : UCIP_SP_2022_71098_102953.jpg

LS view: Toe from crown.

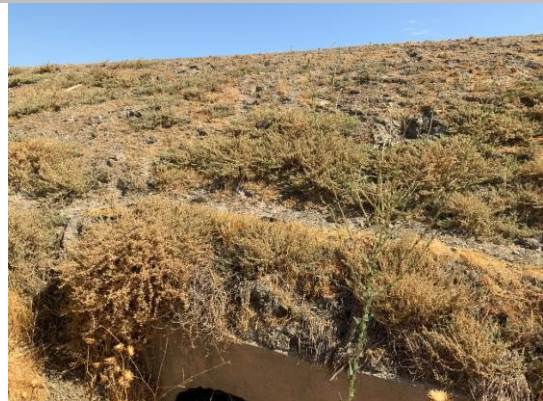
Photo 3 of 3 : UCIP_SP_2022_71098_102954.jpg

LS view: Slope from toe.

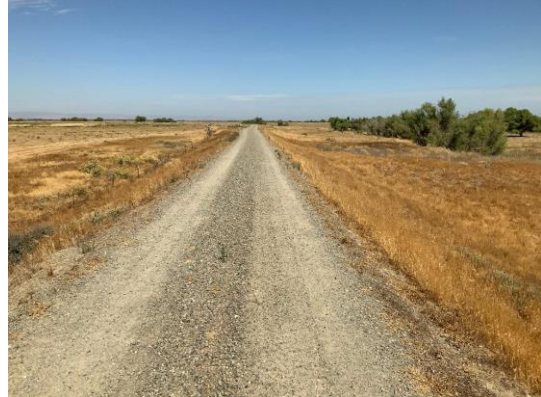
Photo 1 of 3 : UCIP_SP_2022_71099_102957.jpg

Comment Code					
Inspector Comment					
FS_ID:71099 DS_ID:19823 EP_NO: N/A Repair Type: Non-Urgent Crossing Status: Not Found UCIP Comments: 07/27/2021 The record remains Non-Urgent. No signs of pipe, headwalls, or flapgate found on WS or LS. Confirm with owner on the status of this pipe. No permit was found authorizing this encroachment. CVFPB will need to review crossing to determine owner. The UCIP inspection was completed with GEI staff, P. Espinoza. (H. Dunn ? GEI) 04/18/2014 Alignment of crossing unknown--altered crossing. No headwall found on landward side only siphon breaker found a short distance from landward toe. Tall grass observed on waterward slope and some burrow activity also noticed. Need to contact owner to determine alignment of crossing and status of crossing. (O. Magana - DWR UCIP) FIELD_STRUCT_DESC: 36-inch corrugated metal gravity drainage pipe (CMP) through the levee, 15.7 feet below the crown. Flap gate on the waterside (WS) end. Concrete U-shaped headwall on each end. Bench mark (BM) stamped 9770-152 on top of the WS headwall. [Additional Reference(s): DWR Levee Log, 2002, (HLM 3.44). USACE San Joaquin O&M Manual, Unit No. 601, Part No. 1, 1967, Amended in 1978, Revised 20 June 1985, (HLM 3.43). DWR As-Built Specification No. 61-01, Sheet No. 47, 7 March 1961, (HLM 3.43)]. FS Date: 7/27/2021

Levee crown.

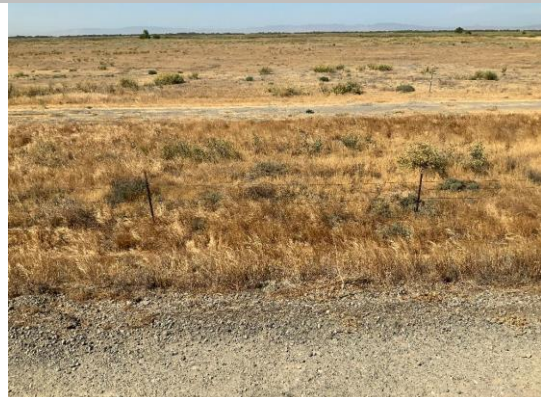
Photo 2 of 3 : UCIP_SP_2022_71099_102958.jpg

LS view: Toe from crown.

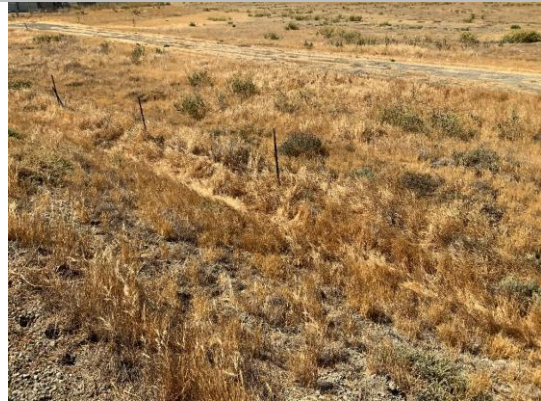
Photo 3 of 3 : UCIP_SP_2022_71099_102959.jpg

LS view: Slope from the crown, no pipe visible.

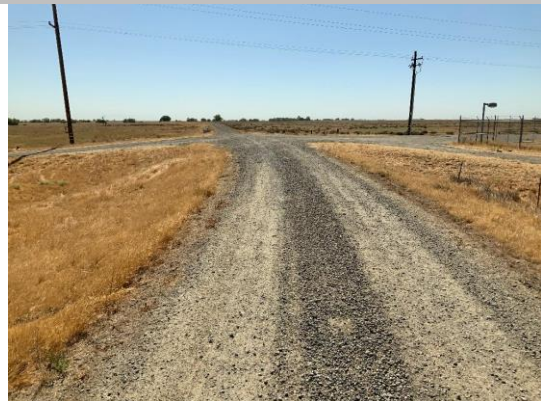
Photo 1 of 3 : UCIP_SP_2022_71100_102964.jpg

FS_ID:71100
DS_ID:19824
EP_NO: 6965
Repair Type: Non-Urgent
Crossing Status: Indicator Found
UCIP Comments: 07/27/2021 The record remains Non-Urgent.
Crossing appears to be modified, there is no WS pump or platform. No sign of pipe visible on LS, unless pipe goes to large plant facility off the toe. Confirm with owner on the alignment and status of pipe. The UCIP inspection was completed with GEI staff, P. Espinoza. (H. Dunn ? GEI)

Levee crown.

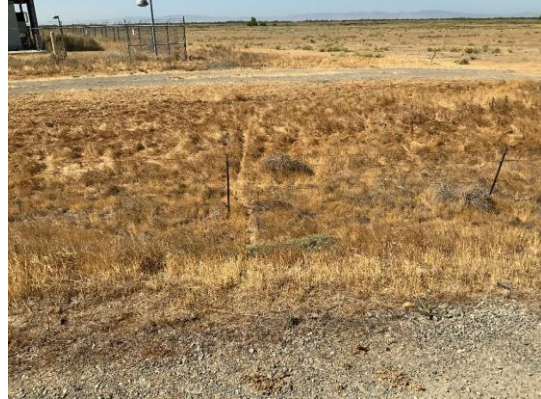
Photo 2 of 3 : UCIP_SP_2022_71100_102965.jpg

LS view: Toe from crown, no pipe visible.

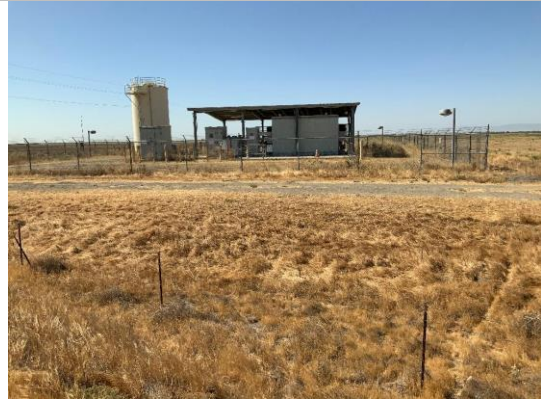
Photo 3 of 3 : UCIP_SP_2022_71100_102966.jpg

LS view: Plant facility visible off the toe from crown.
