**Flood Control Project Maintenance
Levee Inspections
LMA District Cover Sheet**

Lower San Joaquin Levee District

**Flood Control Project Maintenance
Levee Inspections
Unit Cover Sheet**

Levee Inspection Report By Mile - Spring 2022

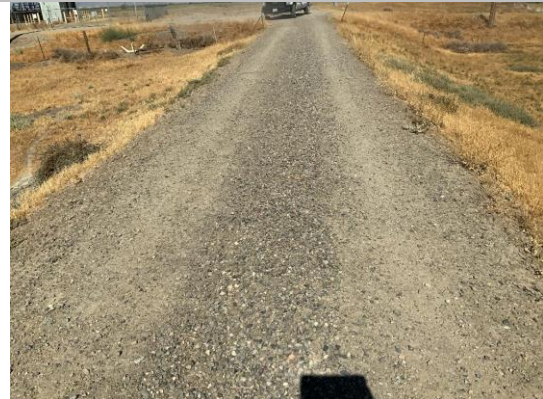
Photo 1 of 3 : UCIP_SP_2022_71101_102976.jpg

Comment Code						
Inspector Comment						
FS_ID:71101 DS_ID:19825 EP_NO: N/A Repair Type: Non-Urgent Crossing Status: Found UCIP Comments: 07/27/2021 The record remains Non-Urgent. DWR DMP internal inspection has found pipe integrity issues. LOF of crossing is between 4.1 and 5. Crossing will be monitored until funding becomes available for rehabilitation. WS riser has broken cover, creating a safety hazard. Limited inspection due to dense tumbleweeds over LS inlet, recommend removal. No permit was found authorizing this encroachment. CVFPB will need to review crossing to determine owner. The UCIP inspection was completed with GEI staff, P. Espinoza. (H. Dunn ? GEI) 04/18/2014 Sediment buildup inside pipe visible from landward side. Excess soil is also present on landward toe partially blocking concrete headwall and inlet. Recommend removing soil from landward toe and clear buildup inside. (O. Magana - DWR UCIP) FIELD_STRUCT_DESC: 36-inch corrugated metal gravity drainage pipe (CMP) through the levee, 6.8 feet below the crown. Slide gate in a 48-inch CMP riser unit on the waterside (WS) slope. Concrete headwall on each end. Pipe connects to a 30-inch steel drainage pipe on the WS. Drainage pipe extends to the pump on the WS on a support platform in the channel. (30-inch drainage pipe and pump authorized under Permit No. 12527, 1979 - Joseph Gallo). [Additional Reference(s): DWR Levee Log, 2002, (HLM 3.54). USACE San Joaquin O&M Manual, Unit No. 601, Part No. 1, 1967, Amended in 1978, Revised 20 June 1985, (HLM 3.54). DWR As-Built Specification No. 61-01, Sheet No. 47, 7 March 1961, (HLM 3.54)]. FS Date: 7/27/2021

Levee crown.

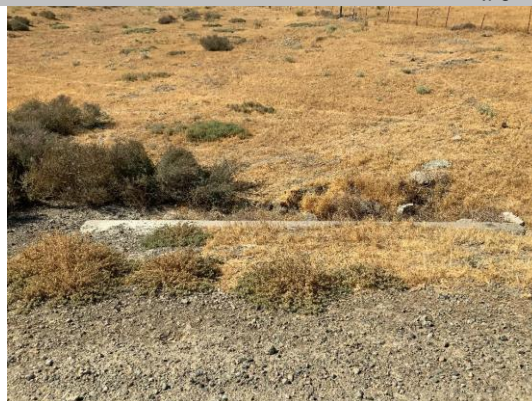
Photo 2 of 3 : UCIP_SP_2022_71101_102972.jpg

LS view: Headwall visible at toe from crown.

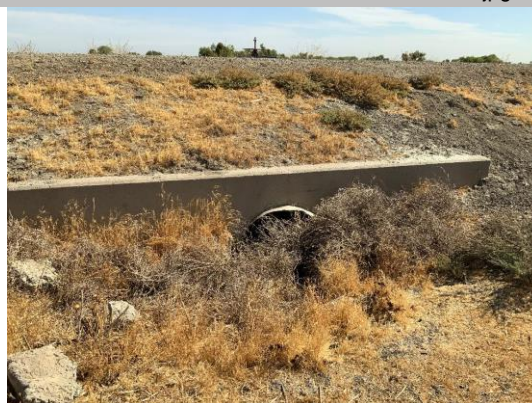
Photo 3 of 3 : UCIP_SP_2022_71101_102973.jpg

LS view: Headwall and slope from toe.

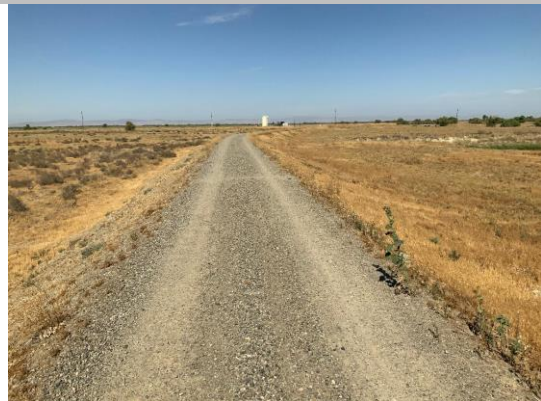
Photo 1 of 3 : UCIP_SP_2022_71102_102981.jpg

Comment Code						
Inspector Comment						
FS_ID:71102						
DS_ID:19826						
EP_NO: N/A						
Repair Type: Non-Urgent						
Crossing Status: Found						
UCIP Comments: 07/27/2021 The record remains Non-Urgent. DWR						
DMP internal inspection has found pipe integrity issues. LOF of						
crossing is between 4.1 and 5. Crossing will be monitored until funding						
becomes available for rehabilitation. Limited inspection of LS pipe inlet						
due to vegetation covering it, recommend removal. Exterior liner of WS						
flapgate is significantly chipping off. No permit was found authorizing						
this encroachment. CVFPB will need to review crossing to determine						
owner. The UCIP inspection was completed with GEI staff, P.						
Espinoza. (H. Dunn ? GEI) 04/18/2014 Sediment buildup inside						
crossing and is visible from landward side. Recommend clearing						
sediment buildup inside pipe and check wall integrity to determine

condition. (O. Magana - DWR UCIP)						
FIELD_STRUCT_DESC: 24-inch corrugated metal gravity drainage						
pipe (CMP) through the levee, 7.0 feet below the crown. Flap gate on						
the waterside (WS) end. Concrete headwall on each end. [Additional						
Reference(s): DWR Levee Log, 2002, (HLM 3.78). USACE San Joaquin						
O&M Manual, Unit No. 601, Part No. 1, 1967, Amended in 1978,						
Revised 20 June 1985, (HLM 3.77). DWR As-Built Specification No. 61-						
01, Sheet No. 47, 7 March 1961, (HLM 3.77)].						
FS Date: 7/27/2021

Levee crown.

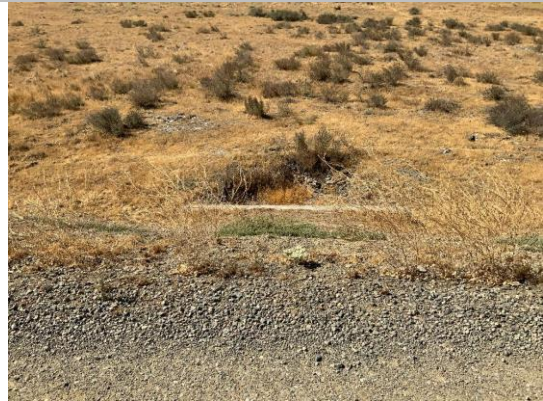
Photo 2 of 3 : UCIP_SP_2022_71102_102982.jpg

LS view: Headwall visible at toe from crown.

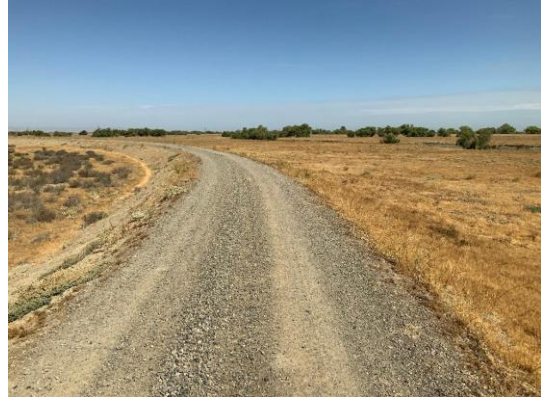
Photo 1 of 3 : UCIP_SP_2022_71103_102994.jpg

Comment Code					
Inspector Comment					
FS_ID:71103 DS_ID:19827 EP_NO: N/A Repair Type: Non-Urgent Crossing Status: Found UCIP Comments: 07/27/2021 The record remains Non-Urgent. DWR DMP internal inspection has found pipe integrity issues. LOF of crossing is between 4.1 and 5. Crossing will be monitored until funding becomes available for rehabilitation. No permit was found authorizing this encroachment. CVFPB will need to review crossing to determine owner. The UCIP inspection was completed with GEI staff, P. Espinoza. (H. Dunn ? GEI) 04/18/2014 Sediment buildup inside crossing and is visible from landward side. Recommend clearing sediment buildup inside pipe and check wall integrity to determine condition. (O. Magana - DWR UCIP) FIELD_STRUCT_DESC: 36-inch corrugated metal gravity drainage pipe (CMP) through the levee, 6.7 feet below the crown. Slide gate in a 48-inch CMP riser unit on the waterside (WS) slope. [Additional Reference(s): DWR Levee Log, 2002, (HLM 3.98). USACE San Joaquin O&M Manual, Unit No. 601, Part No. 1, 1967, Amended in 1978, Revised 20 June 1985, (HLM 3.97). DWR As-Built Specification No. 61-01, Sheet No. 47, 7 March 1961, (HLM 3.97)]. FS Date: 7/27/2021

Levee crown.

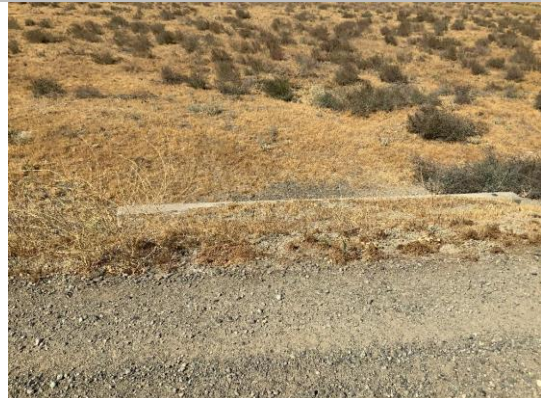
Photo 2 of 3 : UCIP_SP_2022_71103_102995.jpg

LS view: Headwall visible at toe from crown.

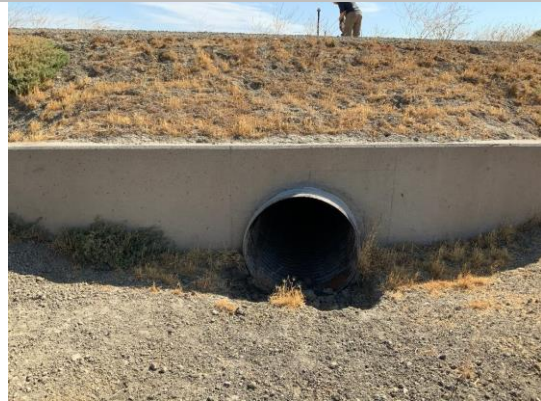
Photo 3 of 3 : UCIP_SP_2022_71103_102996.jpg

LS view: Headwall and slope from toe.

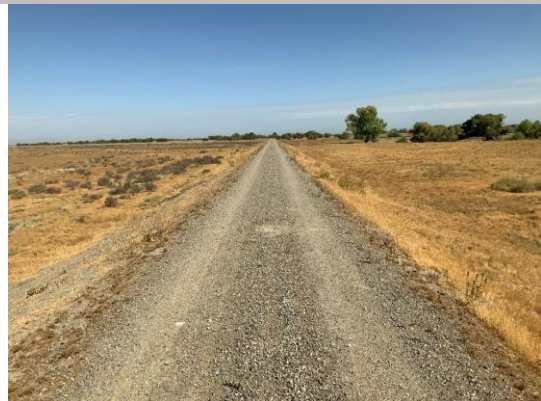
Photo 1 of 3 : UCIP_SP_2022_71104_103005.jpg

FS_ID:71104
DS_ID:19828
EP_NO: N/A
Repair Type: Non-Urgent
Crossing Status: Found
UCIP Comments: 07/27/2021 The record remains Non-Urgent. Limited inspection due to LS pipe inlet being covered by dense tumbleweeds, recommend removal. No permit was found authorizing this encroachment. CVFPB will need to review crossing to determine owner. The UCIP inspection was completed with GEI staff, P. Espinoza. (H. Dunn ? GEI) 04/18/2014 Dense vegetation limits the inspector's visibility to identify signs of pipe condition on landward toe--headwall blocked by dense vegetation. Recommend removing vegetation from landward toe. (O. Magana - DWR UCIP)
FIELD_STRUCT_DESC: 24-inch corrugated metal gravity drainage pipe (CMP) through the levee, 10.8 feet below the crown. Flap gate on the waterside (WS) end. Concrete headwall on each end. [Additional Reference(s): DWR Levee Log, 2002, (HLM 4.17). USACE San Joaquin O&M Manual, Unit No. 601, Part No. 1, 1967, Amended in 1978, Revised 20 June 1985, (HLM 4.17). DWR As-Built Specification No. 61-01, Sheet No. 48, 7 March 1961, (HLM 4.17)].

Levee crown.

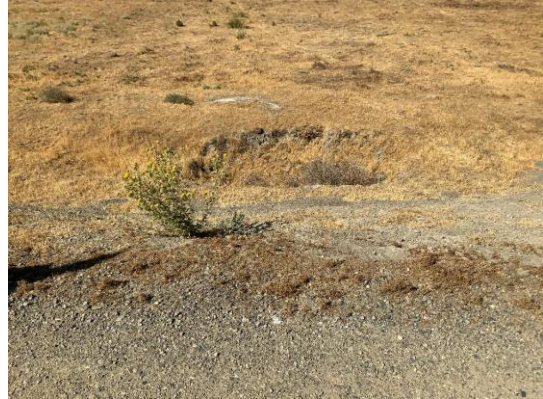
Photo 2 of 3 : UCIP_SP_2022_71104_103006.jpg

LS view: Toe from crown.

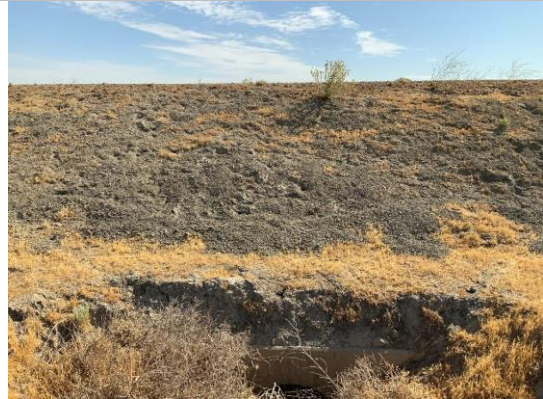
Photo 3 of 3 : UCIP_SP_2022_71104_103007.jpg

LS view: Slope from toe.

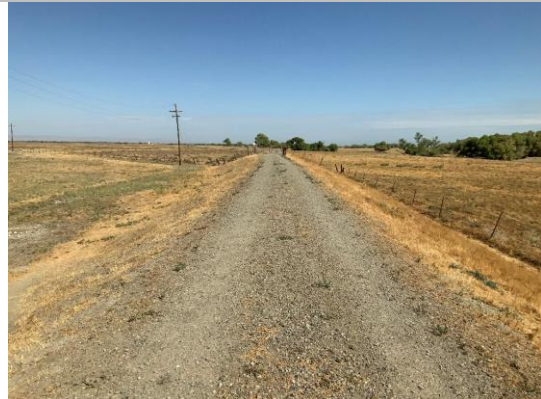
Photo 1 of 3 : UCIP_SP_2022_71106_103030.jpg

FS_ID:71106
 DS_ID:19830
 EP_NO: N/A
 Repair Type: Non-Urgent
 Crossing Status: Found
 UCIP Comments: 07/27/2021 The record remains Non-Urgent. WS riser has no cover, causing safety hazard. Limited inspection due to LS pipe inlet completely buried within large dirt pile, recommend clearing out. No permit was found authorizing this encroachment. CVFPB will need to review crossing to determine owner. The UCIP inspection was completed with GEI staff, P. Espinoza. (H. Dunn ? GEI) 04/18/2014 Sediment buildup inside crossing visible from landward side. Recommend clearing sediment buildup inside pipe and check wall integrity to determine condition. (O. Magana - DWR UCIP)
 FIELD_STRUCT_DESC: 36-inch corrugated metal gravity drainage pipe (CMP) through the levee, 6.9 feet below the crown. Slide gate in a 48-inch CMP riser unit on the waterside (WS) slope. Concrete headwall on the landside (LS) end. Concrete saddle and apron on the WS end.

Levee crown.

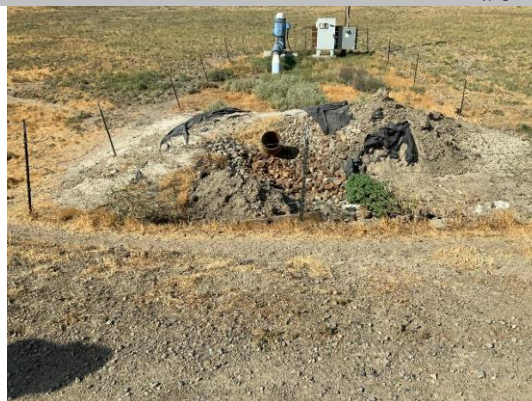
Photo 2 of 3 : UCIP_SP_2022_71106_103031.jpg

LS view: Toe from crown.

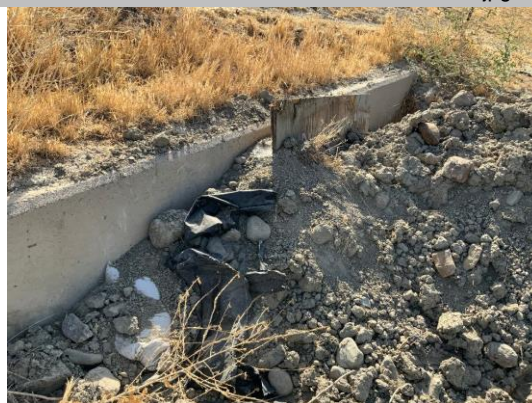
Photo 3 of 3 : UCIP_SP_2022_71106_103032.jpg

LS view: Pile of dirt completely covering pipe inlet at toe.

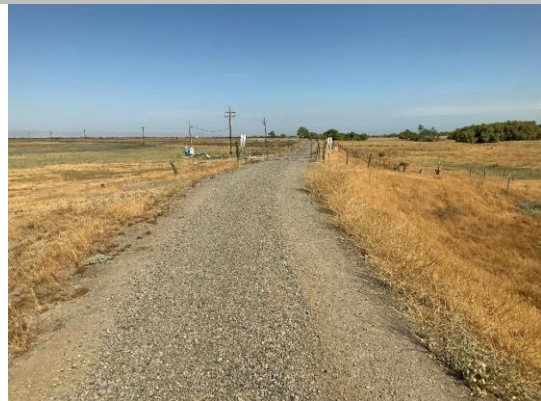
Photo 1 of 3 : UCIP_SP_2022_71107_103037.jpg

Comment Code						
Inspector Comment						
FS_ID:71107 DS_ID:19831 EP_NO: N/A Repair Type: Urgent Crossing Status: Found UCIP Comments: 07/27/2021 The record has been upgraded from Non-Urgent to Urgent. DWR DMP internal inspection has found pipe integrity issues. LOF of crossing is greater than or equal to 5. Crossing will be monitored until funding becomes available to address the issues. Vegetation over LS pipe inlet, recommend removal. No permit was found authorizing this encroachment. CVFPB will need to review crossing to determine owner. The UCIP inspection was completed with GEI staff, P. Espinoza. (H. Dunn ? GEI)04/18/2014 Need to contact owner. Recommend removing tall grass on landward toe to determine condition of crossing from landward side. (O. Magana - DWR UCIP) FIELD_STRUCT_DESC: 24-inch corrugated metal gravity drainage pipe (CMP) through the levee, 11.8 feet below the crown. Flap gate on the waterside (WS) end. Concrete headwall on each end. [Additional Reference(s): DWR Levee Log, 2002, (HLM 4.75). USACE San Joaquin O&M Manual, Unit No. 601, Part No. 1, 1967, Amended in 1978, Revised 20 June 1985, (HLM 4.75). DWR As-Built Specification No. 61-01, Sheet No. 48, 7 March 1961, (HLM 4.75)]. FS Date: 7/27/2021

Levee crown.

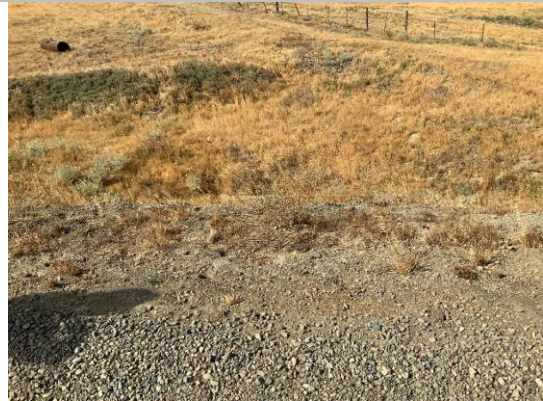
Photo 2 of 3 : UCIP_SP_2022_71107_103038.jpg

LS view: Toe from crown.

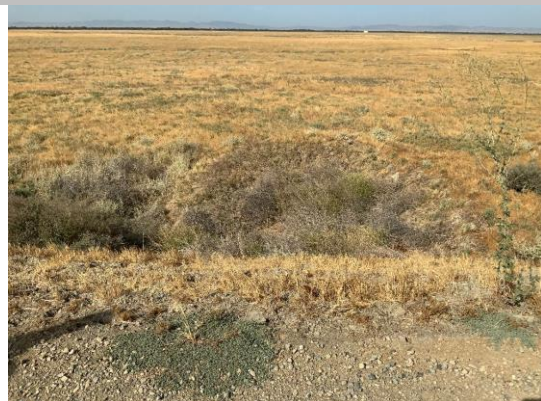
Photo 2 of 3 : UCIP_SP_2022_71108_103047.jpg

LS view: Toe from crown.

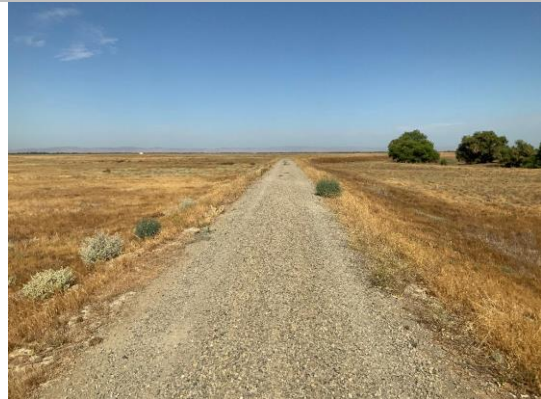
Photo 1 of 3 : UCIP_SP_2022_71109_103067.jpg

FS_ID:71109
DS_ID:19863
EP_NO: N/A
Repair Type: Non-Urgent
Crossing Status: Found
UCIP Comments: 07/27/2021 The record remains Non-Urgent. DWR DMP internal inspection has found pipe integrity issues. LOF of crossing is greater than or equal to 4.1 and less than 5. Crossing will be monitored until funding becomes available for rehabilitation. No permit was found authorizing this encroachment. CVFPB will need to review crossing to determine owner. The UCIP inspection was completed with GEI staff, P. Espinoza. (H. Dunn ? GEI) 04/18/2014 Clear vegetation from waterward slope and landward headwall. (O. Magana - DWR UCIP) FIELD_STRUCT_DESC: 24-inch corrugated metal gravity drainage pipe (CMP) through the levee, 10.9 feet below the crown. Flap gate on the waterside (WS) end. Concrete headwall on each end. [Additional Reference(s): DWR Levee Log, 2002, (HLM 5.35). USACE San Joaquin O&M Manual, Unit No. 601, Part No. 1, 1967, Amended in 1978, Revised 20 June 1985, (HLM 5.34). DWR As-Built Specification No. 61-01, Sheet No. 48, 7 March 1961, (HLM 5.34)].

Levee crown.

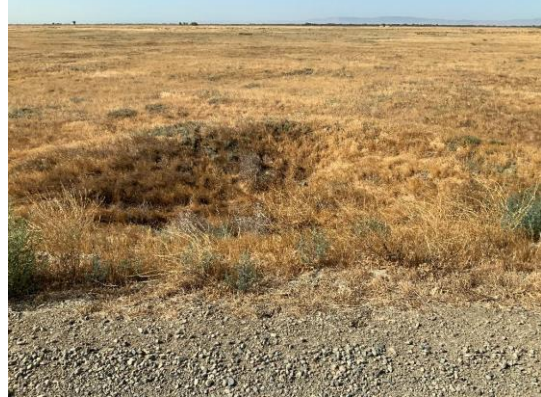
Photo 2 of 3 : UCIP_SP_2022_71109_103068.jpg

LS view: Toe from crown.

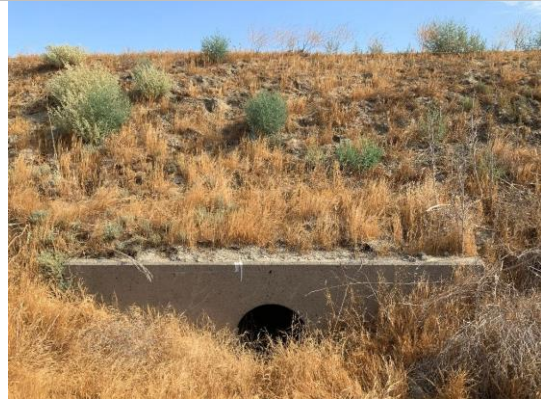
Photo 3 of 3 : UCIP_SP_2022_71109_103069.jpg

LS view: Headwall and slope from toe.

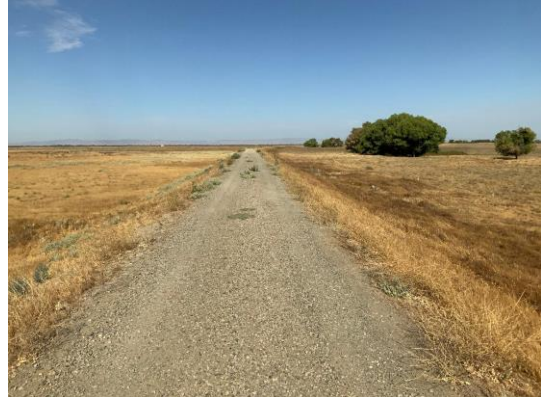
Photo 1 of 3 : UCIP_SP_2022_71110_103076.jpg

Comment Code						
Inspector Comment						
FS_ID:71110 DS_ID:19864 EP_NO: N/A Repair Type: Non-Urgent Crossing Status: Found UCIP Comments: 07/27/2021 The record remains Non-Urgent. DWR DMP internal inspection has not found pipe integrity issues. LOF of crossing is less or equal to 4.0. Recommend next video inspection in 5 years. Limited inspection due to vegetation over LS pipe inlet, recommend removal. No permit was found authorizing this encroachment. CVFPB will need to review crossing to determine owner. The UCIP inspection was completed with GEI staff, P. Espinoza. (H. Dunn ? GEI) 04/18/2014 Dense vegetation limits the inspector's visibility to identify signs of pipe failure (leaks) along the waterward slope. Recommend removing vegetation along pipe alignment to conduct proper inspection of structure. Also recommend removing excess vegetation at landward headwall. (O. Magana - DWR UCIP) FIELD_STRUCT_DESC: 24-inch corrugated metal gravity drainage pipe (CMP) through the levee, 11.0 feet below the crown. Flap gate on the waterside (WS) end. Concrete headwall on each end. [Additional Reference(s): DWR Levee Log, 2002, (HLM 5.63). USACE San Joaquin O&M Manual, Unit No. 601, Part No. 1, 1967, Amended in 1978, Revised 20 June 1985, (HLM 5.63). DWR As-Built Specification No. 61-01, Sheet No. 49, 7 March 1961, (HLM 5.63)]. FS Date: 7/27/2021

Levee crown.

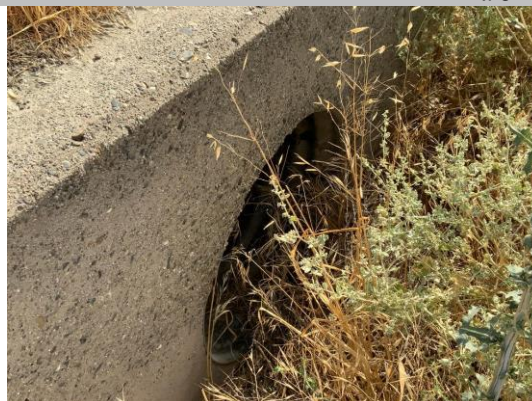
Photo 3 of 3 : UCIP_SP_2022_71110_103078.jpg

LS view: Closeup of pipe inlet at toe with vegetation growth.

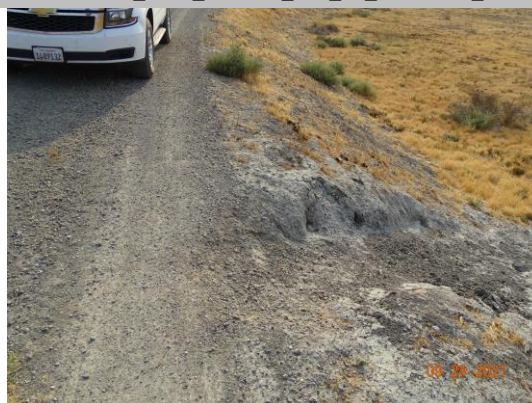
Photo 1 of 1 : SP_2022_NA0010_124_66_20220308_00006.jpg

LM Start	5.77	Rating **	U	Issue No.	66
LM End	5.77	Issue Type +	Ma	Location *	LS
Category	Earthen Levee			GPS Latitude/Longitude	
				Start	End
Item	Erosion / Livestock			37.238354 °	37.238354 °
				-120.742480 °	-120.742480 °
DWR ID	DWR_NA0010_06_f _ 2017_66				
Comment Code					
E4 : Repair the levee slope damaged by livestock and prevent large animal access.					
Inspector Comment					
There is damage to the landside slope and shoulder from livestock.

View of damage to landside slope from livestock traffic looking downstream. (Fall 2021)

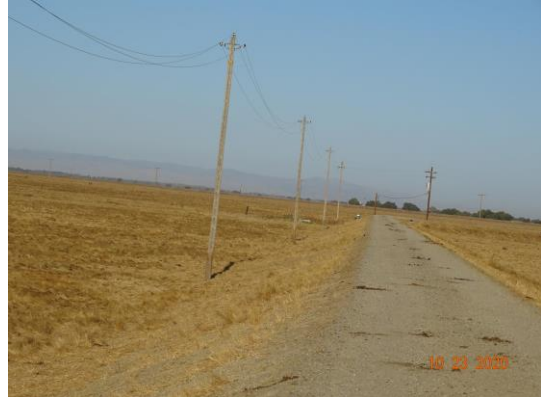
Photo 1 of 1 : SP_2022_NA0010_124_69_20220308_00009.jpg

LM Start	5.93	Rating **	M	Issue No.	69
LM End	7.09	Issue Type +	En	Location *	LS
Category	Earthen Levee			GPS Latitude/Longitude	
				Start	End
Item	Encroachments			37.236936 °	37.226800 °
				-120.740384 °	-120.724736 °
DWR ID	DWR_NA0010_06_s_ 2022_69				
Comment Code					
PO : Pole					
Inspector Comment					
There are several PG&E poles within this section at the landside toe and slope.

Looking downstream at PG&E poles on the landside slope and toe. (Fall 2020)

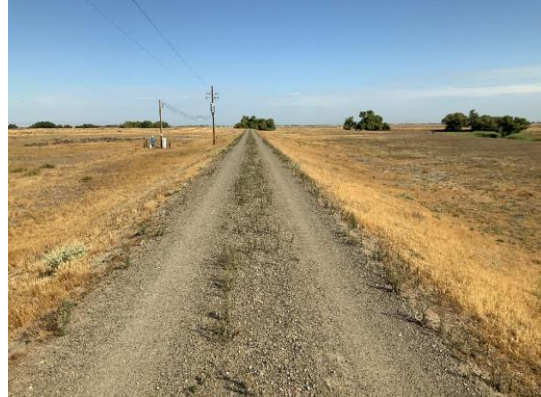
Photo 1 of 3 : UCIP_SP_2022_71111_103092.jpg

FS_ID:71111
DS_ID:19865
EP_NO: N/A
Repair Type: Non-Urgent
Crossing Status: Found
UCIP Comments: 07/27/2021 The record has been upgraded from No Action Needed to Non-Urgent. No permit was found authorizing this encroachment. CVFPB will need to review crossing to determine owner. Crossing appears to be in good condition. Separate 10 inch plastic pipe inlet and flowmeter off the LS toe across this Crossing's inlet. The UCIP inspection was completed with GEI staff, P. Espinoza. (H. Dunn ? GEI)

7/19/2016 Site has been repaired on WS and LS (see photos below). (O. Magana - DWR UCIP)5/26/2016 Erosion is undermining the WS headwall of drainage structure (photos of WS headwall provided by DWR Inspector R. Willoughby). Potential pipe failure at the outlet just behind headwall, recommend completing internal wall integrity of pipe length through levee to determine extent of damage to pipe. (O. Magana - DWR UCIP)4/18/2014 Need to contact owner. Sediment buildup in pipe visible on landside--recommend clearing. (O. Magana - DWR UCIP)
FIELD_STRUCT_DESC: 24-inch corrugated metal gravity drainage pipe (CMP) through the levee, 9.0 feet below the crown. Flap gate on the waterside (WS) end. Concrete headwall on each end. [Additional Reference(s): DWR Levee Log, 2002, (HLM 6.06). USACE San Joaquin O&M Manual, Unit No. 601, Part No. 1, 1967, Amended in 1978, Revised 20 June 1985, (HLM 6.06). DWR As-Built Specification No. 61-01, Sheet No. 49, 7 March 1961, (HLM 6.06)].

Levee crown.

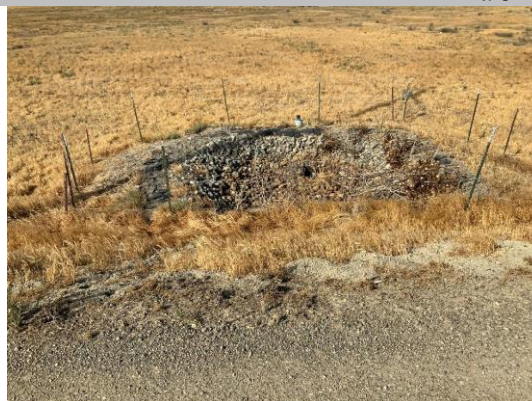
Photo 2 of 3 : UCIP_SP_2022_71111_103093.jpg

LS view: Toe from crown.

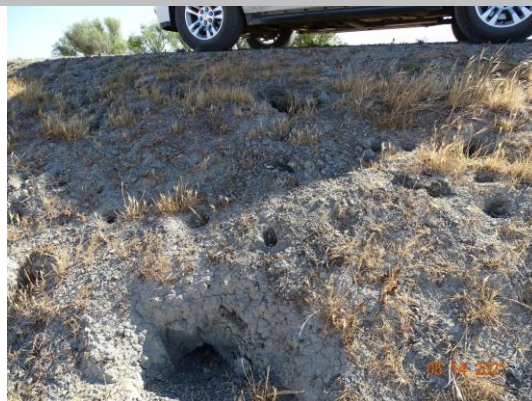
Photo 1 of 1 : SP_2022_NA0010_124_90_20220308_00024.jpg

LM Start	6.63	Rating **	M	Issue No.	90
LM End	6.63	Issue Type +	Ma	Location *	LS
Category	Earthen Levee			GPS Latitude/Longitude	
				Start	End
Item	Animal Control			37.231384 °	37.231384 °
				-120.730297 °	-120.730297 °
DWR ID	DWR_NA0010_06_s_2021_90				
Comment Code					
A3 : No rodents visible, but rodent burrows visible; need to backfill and compact or grout burrows.					
Inspector Comment

Looking at multiple rodent holes in the landside slope. (Spring 2021)

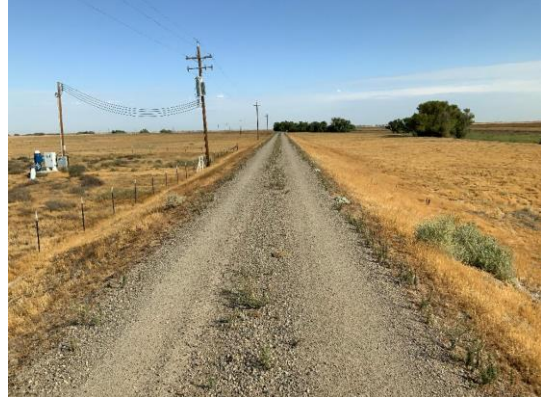
Photo 1 of 3 : UCIP_SP_2022_71112_103109.jpg

FS_ID:71112
DS_ID:19866
EP_NO: N/A
Repair Type: Non-Urgent
Crossing Status: Found
UCIP Comments: 07/27/2021 The record has been upgraded from No Action Needed to Non-Urgent. Crossing appears to be in good condition. No permit was found authorizing this encroachment. CVFPB will need to review crossing to determine owner. The UCIP inspection was completed with GEI staff, P. Espinoza. (H. Dunn ? GEI)
FIELD_STRUCT_DESC: 24-inch corrugated metal gravity drainage pipe (CMP) through the levee, 7.0 feet below the crown. Slide gate in a 36-inch CMP riser unit on the waterside (WS) slope. Concrete headwall on the landside (LS) end. Concrete saddle and apron on the WS end. [Additional Reference(s): DWR Levee Log, 2002, (HLM 6.78). USACE San Joaquin O&M Manual, Unit No. 601, Part No. 1, 1967, Amended in 1978, Revised 20 June 1985, (HLM 6.79). DWR As-Built Specification No. 61-01, Sheet No. 50, 7 March 1961, (HLM 6.79)].

Levee crown.

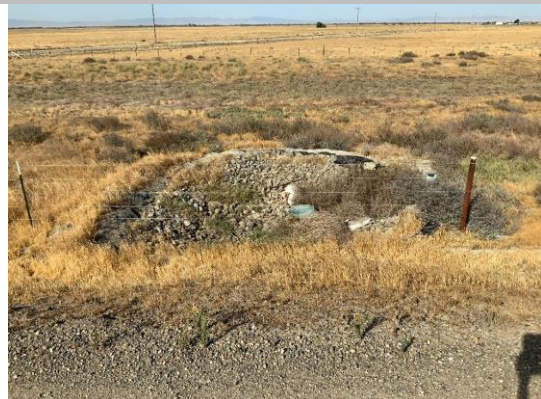
Photo 2 of 3 : UCIP_SP_2022_71112_103106.jpg

LS view: Toe from crown.

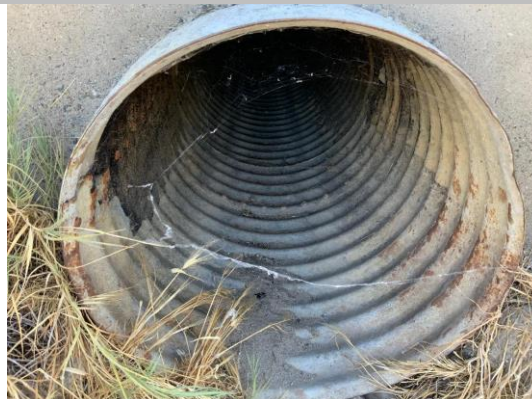
Photo 3 of 3 : UCIP_SP_2022_71112_103107.jpg

LS view: Closeup of pipe inlet at toe.

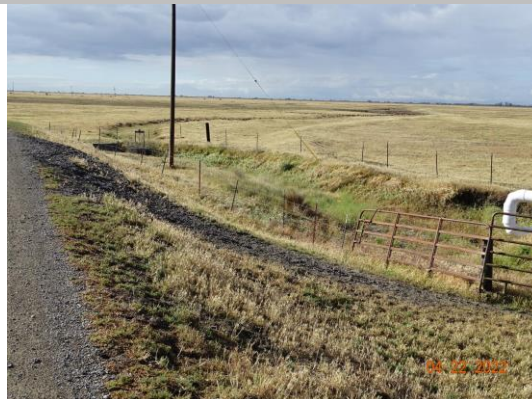
Photo 1 of 1 : SP_2022_NA0010_124_143_20220425_00232.jpg

LM Start	6.88	Rating **	M	Issue No.	143
LM End	6.88	Issue Type +	Ma	Location *	LS
Category	Earthen Levee			GPS Latitude/Longitude	
				Start	End
Item	Erosion / Livestock			37.228370 °	37.228370 °
				-120.728004 °	-120.728004 °
DWR ID	DWR_NA0010_06_s_2022_143				
Comment Code					
E4 : Repair the levee slope damaged by livestock and prevent large animal access.					
Inspector Comment

Levee damage on the landside slope from livestock activity. (Spring 2022)

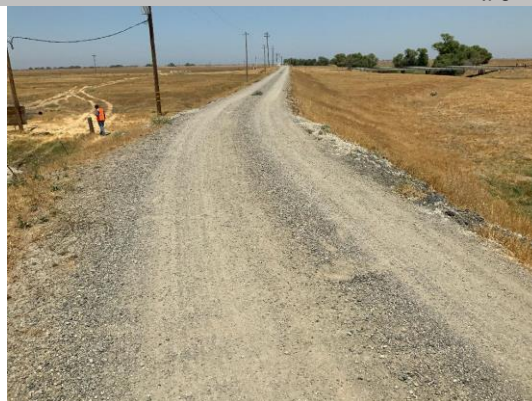
Photo 1 of 3 : UCIP_SP_2022_71113_101625.jpg

Comment Code					
Inspector Comment					
FS_ID:71113 DS_ID:19867 EP_NO: N/A Repair Type: Non-Urgent Crossing Status: Found UCIP Comments: 07/13/2021 The record has been upgraded from No Action Needed to Non-Urgent. The cover on the WS riser is broken, causing a safety concern. There is another riser, pump, and pipe out closer to the channel on the WS but is not within 15 feet of the toe. No permit was found authorizing this encroachment. CVFPB will need to review crossing to determine owner. The UCIP inspection was completed with GEI staff, P. Espinoza. (H. Dunn ? GEI) FIELD_STRUCT_DESC: 36-inch corrugated metal gravity drainage pipe (CMP) through the levee, 10.7 feet below the crown. Slide gate in a 48-inch CMP riser unit on the waterside (WS) slope. Concrete headwall on the landside (LS) end. Concrete U-shaped headwall on the WS end. [Additional Reference(s): DWR Levee Log, 2002, (HLM 6.97). USACE San Joaquin O&M Manual, Unit No. 601, Part No. 1, 1967, Amended in 1978, Revised 20 June 1985, (HLM 6.97). DWR As-Built Specification No. 61-01, Sheet No. 50, 7 March 1961, (HLM 6.97)]. FS Date: 7/13/2021

Levee crown.

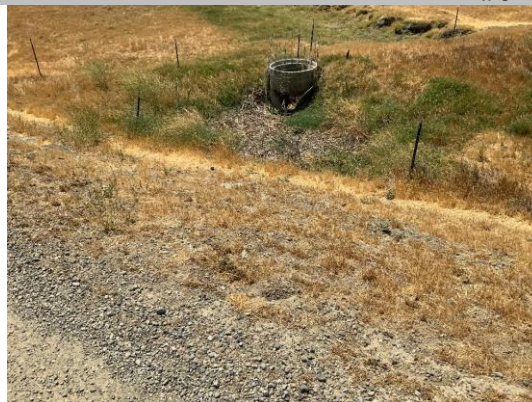
Photo 2 of 3 : UCIP_SP_2022_71113_101628.jpg

LS view: Toe from crown.

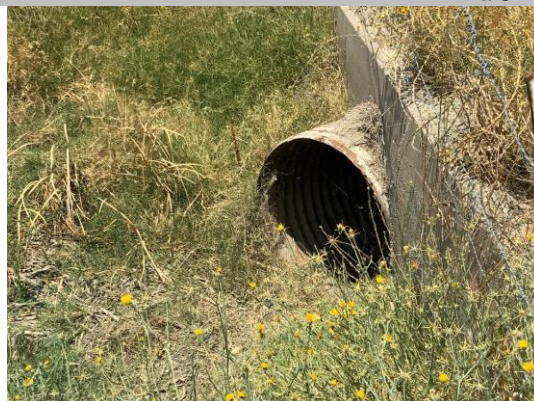
Photo 3 of 3 : UCIP_SP_2022_71113_101629.jpg

LS view: Closeup of pipe inlet at toe.

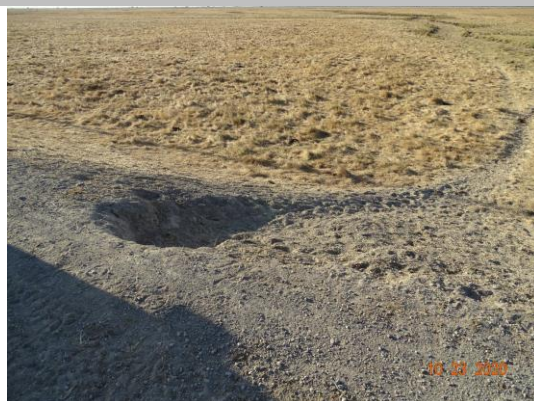
Photo 1 of 1 : SP_2022_NA0010_124_79_20220308_00015.jpg

LM Start	6.92	Rating **	M	Issue No.	79
LM End	6.92	Issue Type +	Ma	Location *	LS
Category	Earthen Levee			GPS Latitude/Longitude	
				Start	End
Item	Erosion / Livestock			37.228054 °	37.228054 °
				-120.727428 °	-120.727428 °
DWR ID	DWR_NA0010_06_f _ 2018_79				
Comment Code					
E4 : Repair the levee slope damaged by livestock and prevent large animal access.					
Inspector Comment					
Slope damage has been repaired with loose soil. Monitor for settlement.

View down the landside slope of damage from livestock. (Fall 2020)

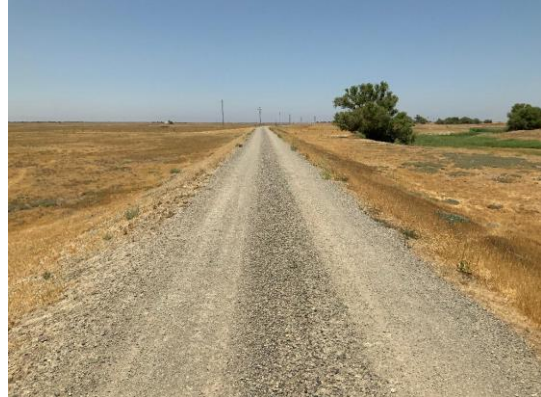
Photo 1 of 3 : UCIP_SP_2022_71114_101634.jpg

Comment Code					
Inspector Comment					
FS_ID:71114 DS_ID:19868 EP_NO: N/A Repair Type: Non-Urgent Crossing Status: Found UCIP Comments: 07/13/2021 Record is still Non-Urgent. DWR DMP internal inspection has found pipe integrity issues. LOF of crossing is between 4.1 and 5. Crossing will be monitored until funding becomes available for rehabilitation. No permit was found authorizing this encroachment. CVFPB will need to review crossing to determine owner. The UCIP inspection was completed with GEI staff, P. Espinoza. (H. Dunn ? GEI) 04/18/2014 Need to contact owner. Clear animal from waterward side. Some sediment buildup in pipe visible landward side--recommend clearing. (O. Magana - DWR UCIP) FIELD_STRUCT_DESC: 24-inch corrugated metal gravity drainage pipe (CMP) through the levee, 10.6 feet below the crown. Flap gate on the waterside (WS) end. Concrete headwall on each end. [Additional Reference(s): DWR Levee Log, 2002, (HLM 7.29). USACE San Joaquin O&M Manual, Unit No. 601, Part No. 1, 1967, Amended in 1978, Revised 20 June 1985, (HLM 7.29). DWR As-Built Specification No. 61-01, Sheet No. 50, 7 March 1961, (HLM 7.29)]. FS Date: 7/13/2021

Levee crown.

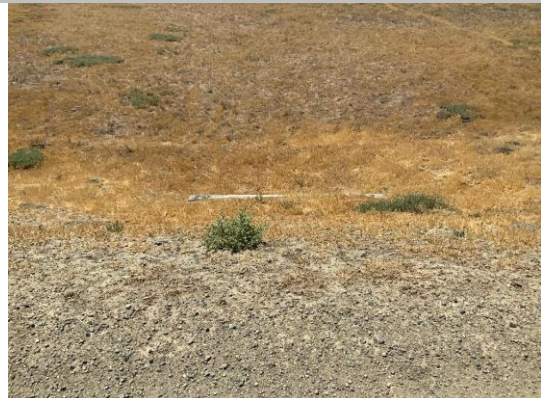
Photo 2 of 3 : UCIP_SP_2022_71114_101638.jpg

LS view: Headwall visible at toe from crown.

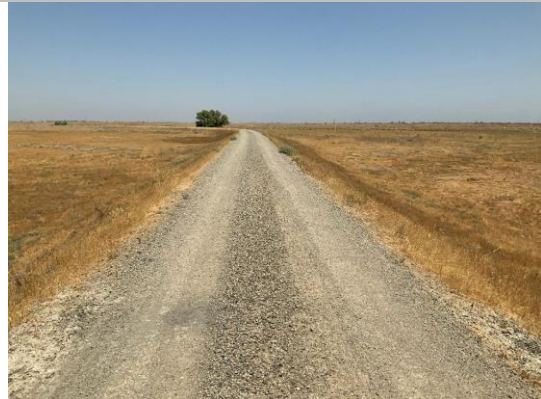
Photo 1 of 3 : UCIP_SP_2022_71115_101643.jpg

FS_ID:71115
DS_ID:19869
EP_NO: N/A
Repair Type: Non-Urgent
Crossing Status: Found
UCIP Comments: 07/13/2021 Record remains Non-Urgent. DWR DMP internal inspection has found pipe integrity issues. LOF of crossing is greater than or equal to 4.1 and less than 5. Crossing will be monitored until funding becomes available for rehabilitation. No longer sediment buildup as mentioned in previous inspection. No permit was found authorizing this encroachment. CVFPB will need to review crossing to determine owner. The UCIP inspection was completed with GEI staff, P. Espinoza. (H. Dunn ? GEI) 04/18/2014 Some sediment buildup in pipe visible on landward side--recommend clearing. (O. Magana - DWR UCIP)
FIELD_STRUCT_DESC: 24-inch corrugated metal gravity drainage pipe (CMP) through the levee, 11.8 feet below the crown. Flap gate on the waterside (WS) end. Concrete headwall on each end. Skewed crossing. [Additional Reference(s): DWR Levee Log, 2002, (HLM 7.74). USACE San Joaquin O&M Manual, Unit No. 601, Part No. 1, 1967, Amended in 1978, Revised 20 June 1985, (HLM 7.74). DWR As-Built Specification No. 61-01, Sheet No. 50, 7 March 1961, (HLM 7.74)].

Levee crown.

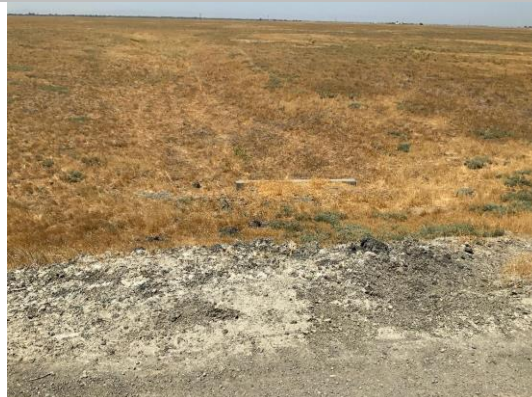
Photo 2 of 3 : UCIP_SP_2022_71115_101644.jpg

LS view: Headwall visible at toe from crown.

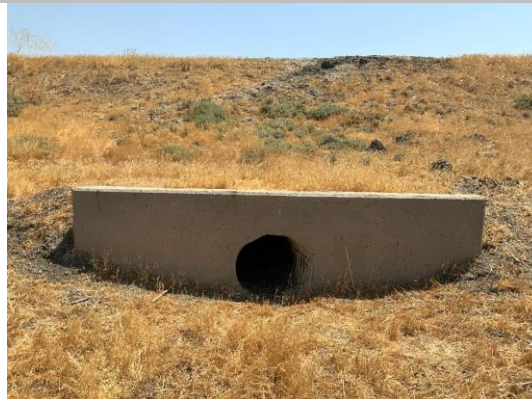
Photo 3 of 3 : UCIP_SP_2022_71115_101645.jpg

LS view: Slope and headwall at toe.

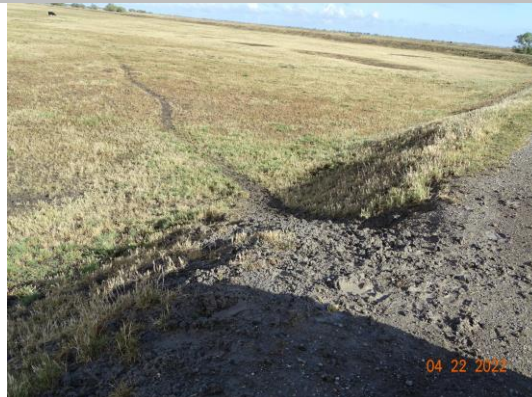
Photo 1 of 1 : SP_2022_NA0010_124_74_20220425_00233.jpg

LM Start	7.66	Rating **	M	Issue No.	74
LM End	7.66	Issue Type +	Ma	Location *	LS
Category	Earthen Levee			GPS Latitude/Longitude	
				Start	End
Item	Erosion / Livestock			37.222689 °	37.222689 °
				-120.716400 °	-120.716400 °
DWR ID	DWR_NA0010_06_f_2018_74				
Comment Code					
E4 : Repair the levee slope damaged by livestock and prevent large animal access.					
Inspector Comment					
Damage to levee slope from livestock access.

Slope damage from livestock. (Spring 2022)

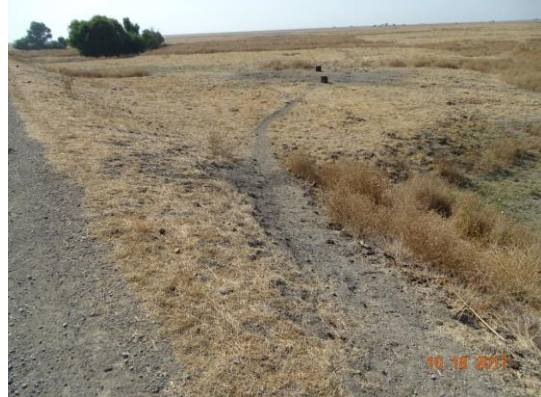
Photo 1 of 1 : SP_2022_NA0010_124_65_20220308_00005.jpg

LM Start	8.08	Rating **	A/W	Issue No.	65
LM End	8.08	Issue Type +	Ma	Location *	LS
Category	Earthen Levee			GPS Latitude/Longitude	
				Start	End
Item	Erosion / Livestock			37.217199 °	37.217199 °
				-120.713374 °	-120.713374 °
DWR ID	DWR_NA0010_06_f _ 2017_65				
Comment Code					
E4 : Repair the levee slope damaged by livestock and prevent large animal access.					
Inspector Comment					
Livestock damage to levee slope.

Looking southwest at the landside slope.

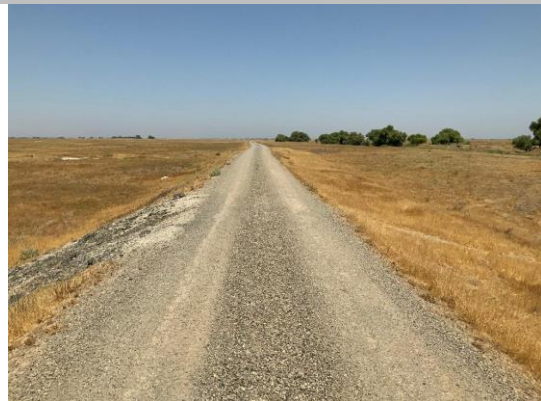
Photo 1 of 3 : UCIP_SP_2022_71116_102248.jpg

Comment Code						
Inspector Comment						
FS_ID:71116 DS_ID:19870 EP_NO: N/A Repair Type: Non-Urgent Crossing Status: Found UCIP Comments: 07/13/2021 Record remains Non-Urgent. DWR DMP internal inspection has found pipe integrity issues. LOF of crossing is greater than or equal to 4.1 and less than 5. Crossing will be monitored until funding becomes available for rehabilitation. Some vegetation buildup over LS pipe inlet and WS flapgate, recommend removal of vegetation on both ends. No permit was found authorizing this encroachment. CVFPB will need to review crossing to determine owner. The UCIP inspection was completed with GEI staff, P. Espinoza. (H. Dunn ? GEI) 04/18/2014 Sediment buildup in pipe--recommend contacting owner to clear sediment. (O. Magana - DWR UCIP) FIELD_STRUCT_DESC: 24-inch corrugated metal gravity drainage pipe (CMP) through the levee, 16.5 feet below the crown. Flap gate on the waterside (WS) end. Concrete headwall on each end. [Additional Reference(s): DWR Levee Log, 2002, (HLM 8.22). USACE San Joaquin O&M Manual, Unit No. 601, Part No. 1, 1967, Amended in 1978, Revised 20 June 1985, (HLM 8.21). DWR As-Built Specification No. 61-01, Sheet No. 51, 7 March 1961, (HLM 8.21)]. FS Date: 7/13/2021

Levee crown.

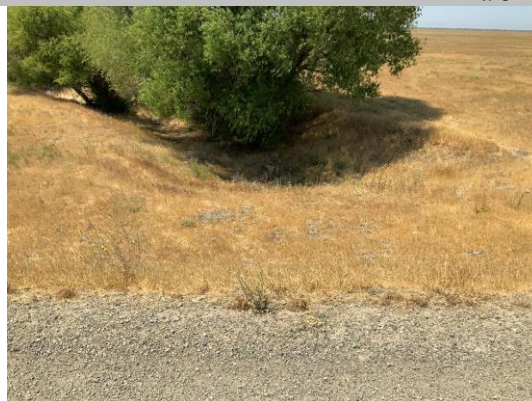
Photo 2 of 3 : UCIP_SP_2022_71116_102249.jpg

LS view: Toe from crown.

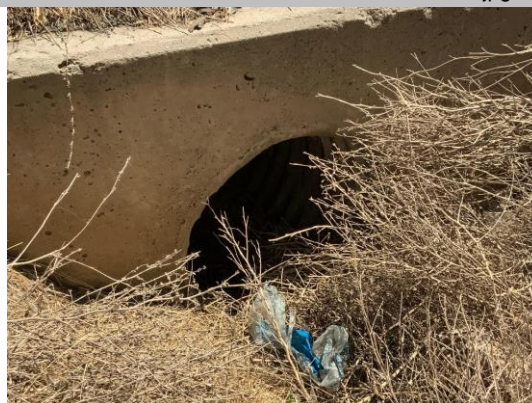
Photo 3 of 3 : UCIP_SP_2022_71116_102250.jpg

LS view: Closeup of pipe inlet at toe. Some vegetation blocking.

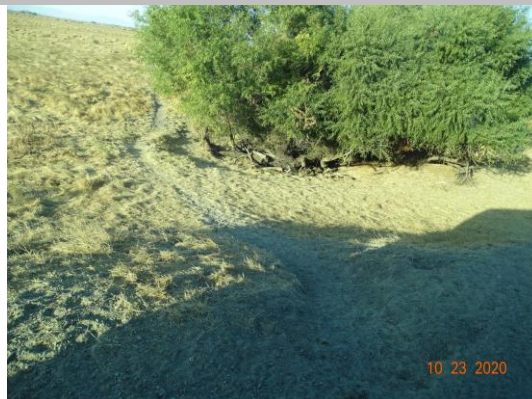
Photo 1 of 1 : SP_2022_NA0010_124_104_20220308_00033.jpg

LM Start	8.20	Rating **	A/W	Issue No.	104
LM End	8.20	Issue Type +	Ma	Location *	LS
Category	Earthen Levee			GPS Latitude/Longitude	
				Start	End
Item	Erosion / Livestock			37.215588 °	37.215588 °
				-120.712406 °	-120.712406 °
DWR ID	DWR_NA0010_06_f_2020_104				
Comment Code					
E4 : Repair the levee slope damaged by livestock and prevent large animal access.					
Inspector Comment					
Slope damage on both sides has been repaired with loose soil. Monitor for settlement.

Livestock damage to the landside slope. (Fall 2020)

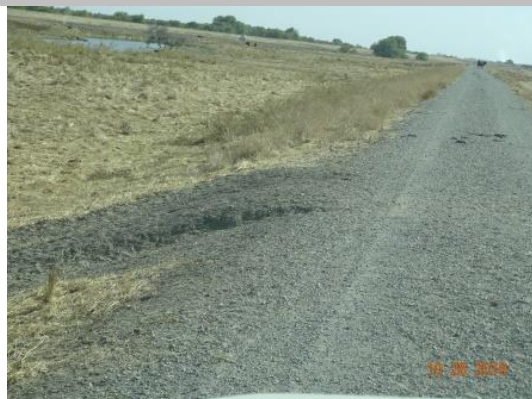
Photo 1 of 1 : SP_2022_NA0010_124_89_20220308_00023.jpg

LM Start	8.32	Rating **	A/W	Issue No.	89
LM End	8.32	Issue Type +	Ma	Location *	WS
Category	Earthen Levee			GPS Latitude/Longitude	
				Start	End
Item	Erosion / Livestock			37.214273 °	37.214273 °
				-120.711100 °	-120.711100 °
DWR ID	DWR_NA0010_06_f _ 2019_89				
Comment Code					
E4 : Repair the levee slope damaged by livestock and prevent large animal access.					
Inspector Comment					
Slope damage has been repaired with loose soil. Monitor for settlement.

View of damage to the waterside slope looking upstream. (Fall 2019)

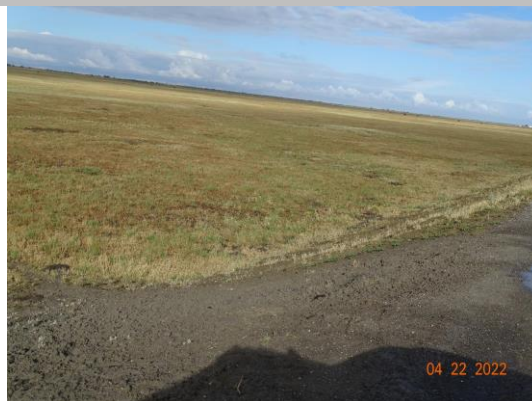
Photo 1 of 1 : SP_2022_NA0010_124_142_20220425_000234.jpg

LM Start	8.33	Rating **	A/W	Issue No.	142
LM End	8.33	Issue Type +	Ma	Location *	LS
Category	Earthen Levee			GPS Latitude/Longitude	
				Start	End
Item	Erosion / Livestock			37.214232 °	37.214232 °
				-120.711025 °	-120.711025 °
DWR ID	DWR_NA0010_06_s_2022_142				
Comment Code					
E4 : Repair the levee slope damaged by livestock and prevent large animal access.					
Inspector Comment

Looking down the levee slope at livestock damage. (Spring 2022)

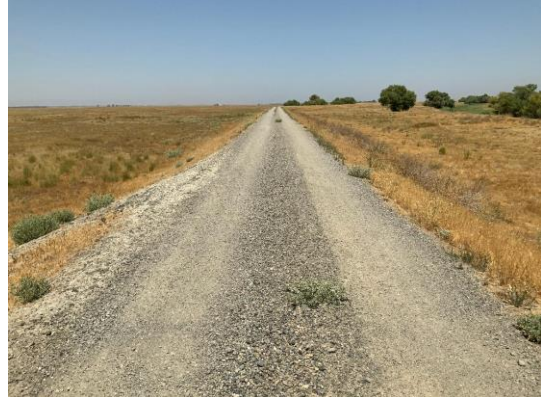
Photo 1 of 3 : UCIP_SP_2022_71117_102254.jpg

Comment Code					
Inspector Comment					
FS_ID:71117 DS_ID:19871 EP_NO: N/A Repair Type: Non-Urgent Crossing Status: Found UCIP Comments: 07/13/2021 Record remains Non-Urgent. DWR DMP internal inspection has found pipe integrity issues. LOF of crossing is between 4.1 and 5. Crossing will be monitored until funding becomes available for rehabilitation. Inside of LS pipe inlet is rusted but no visible holes or deterioration. No permit was found authorizing this encroachment. CVFPB will need to review crossing to determine owner. The UCIP inspection was completed with GEI staff, P. Espinoza. (H. Dunn ? GEI) 04/18/2014 Need to contact owner. Sediment buildup in pipe visible on landward side--recommend clearing. Good candidate for pressure test or video inspection due to signs of heavy corrosion. If no leaks after tests this crossing would be a good candidate for rehabilitation. (O. Magana - DWR UCIP) FIELD_STRUCT_DESC: 24-inch corrugated metal gravity drainage pipe (CMP) through the levee, 9.2 feet below the crown. Flap gate on the waterside (WS) end. Concrete headwall on each end. [Additional Reference(s): DWR Levee Log, 2002, (HLM 8.51). USACE San Joaquin O&M Manual, Unit No. 601, Part No. 1, 1967, Amended in 1978, Revised 20 June 1985, (HLM 8.51). DWR As-Built Specification No. 61-01, Sheet No. 51, 7 March 1961, (HLM 8.51)]. FS Date: 7/13/2021

Levee crown.

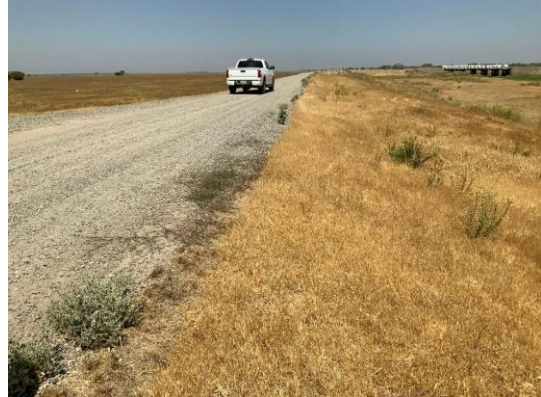
Photo 1 of 3 : UCIP_SP_2022_71118_102262.jpg

Comment Code						
Inspector Comment						
FS_ID:71118 DS_ID:19872 EP_NO: N/A Repair Type: Non-Urgent Crossing Status: Not Found UCIP Comments: 07/13/2021 The record remains Non-Urgent. Cable not found by visual inspection and no service box found. Recommend contacting owner to obtain status of this crossing and alignment. No permit was found authorizing this encroachment. CVFPB will need to review crossing to determine owner. The UCIP inspection was completed with GEI staff, P. Espinoza. (H. Dunn ? GEI)12/05/2014 Accidently missed updating record. Photos have been added and coordinates have been updated. Unable to confirm if crossing is the same cable line originally identified in desk study at levee mile 9.43. Recommend contacting owner to confirm alignment, size of conduit, and permit issued. (O. Magana - DWR UCIP) FIELD_STRUCT_DESC: Telephone cable of an unknown size or material under crown roadway, at an unknown depth. Control structure: telemetering service line. [Additional Reference(s): DWR Levee Log, 2002, (HLM 9.43)]. FS Date: 7/13/2021

Levee crown.

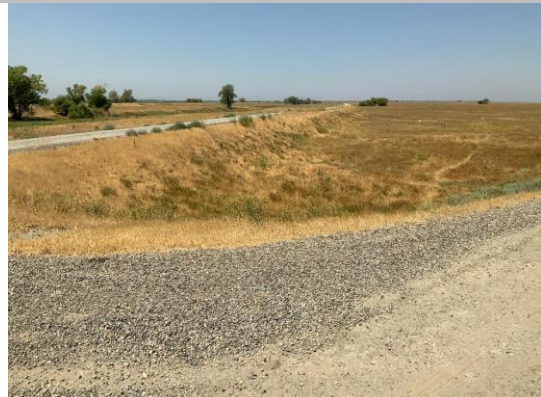
Photo 2 of 3 : UCIP_SP_2022_71118_102264.jpg

LS view: Top of slope, no box visible.

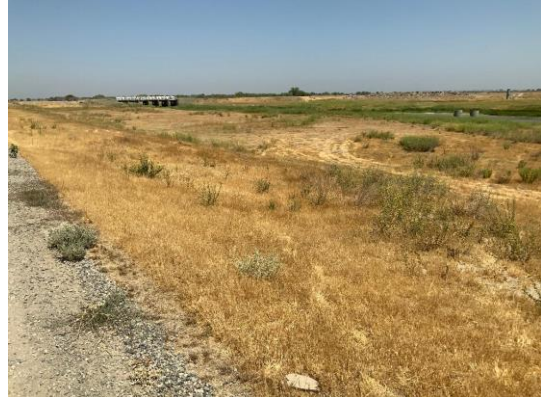
Photo 3 of 3 : UCIP_SP_2022_71118_102263.jpg

WS view: Slope from crown, no box visible.

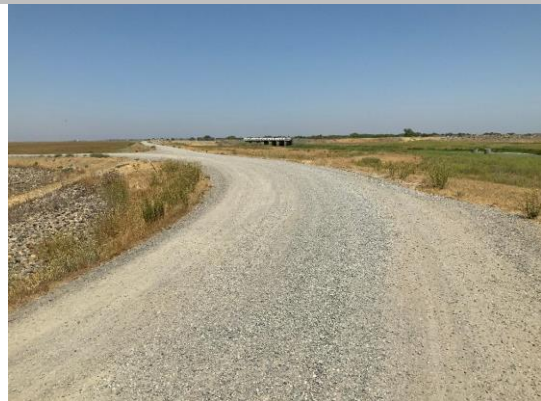
Photo 1 of 3 : UCIP_SP_2022_71119_102272.jpg

FS_ID:71119
DS_ID:19873
EP_NO: N/A
Repair Type: Non-Urgent
Crossing Status: Found
UCIP Comments: 07/13/2021 The record remains Non-Urgent. Standing water on the WS at time of inspection, limited inspection. No permit was found authorizing this encroachment. CVFPB will need to review crossing to determine owner. The UCIP inspection was completed with GEI staff, P. Espinoza. (H. Dunn ? GEI) 12/05/2014. Accidentally missed entry. Photos have been added and coordinates have been updated by Olivia Magana. Unable to determine condition of crossing due to limited access. Recommend contacting owner to provide condition of crossing. (O. Magana - DWR UCIP)
FIELD_STRUCT_DESC: 36-inch corrugated metal gravity drainage pipe (CMP) through the levee, 14.0 feet below the crown. Slide gate in a concrete diversion box on the waterside (WS) shoulder. [Additional Reference(s): DWR Levee Log, 2002, (HLM 9.64)].
FS Date: 7/13/2021

Levee crown.

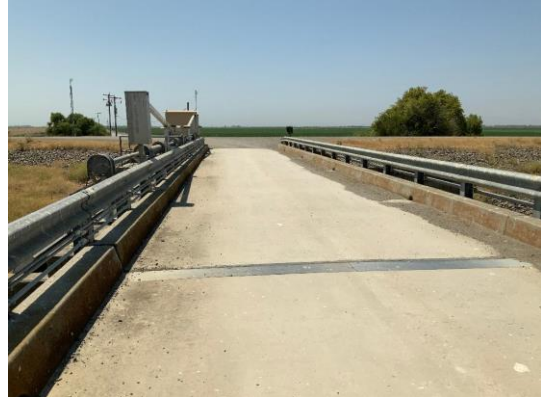
Photo 1 of 3 : UCIP_SP_2022_71159_102276.jpg

Comment Code						
Inspector Comment						
FS_ID:71159 DS_ID:19742 EP_NO: N/A Repair Type: Non-Urgent Crossing Status: Found UCIP Comments: 07/13/2021 The record remains Non-Urgent. No permit was found authorizing this encroachment. CVFPB will need to review crossing to determine owner. Crossing appears in good condition. The UCIP inspection was completed with GEI staff, P. Espinoza. (H. Dunn ? GEI) 10/27/2017 This structure is inspected annually under the Structure and Channel Summer Inspection (part of the Levee Inspection Program) conducted by the DWR Flood Project Integrity and Inspection Branch (FPIIB). (O. Magana - DWR UCIP) 04/21/2014 Accidentally missed--need photos (O. Magana - DWR UCIP) FIELD_STRUCT_DESC: [Mariposa Bypass Control Structure] 1 of 5: Approximately 14 reinforced concrete box gravity drainage culverts (RCBC) of an unknown size across the intersection of the Mariposa Bypass and the Eastside Bypass. Roadway across structure. Controlled slide gates on end four culverts, both sides. Wing wall on each side of the structure. Rock revetment immediately downstream of the structure. [Additional Reference(s): DWR Levee Log, 2002, (HLM 9.64). USACE San Joaquin O&M Manual, Unit No. 601, Part No. 1, 1967, Amended in 1978, Revised 20 June 1985, (HLM 9.64). DWR As-Built Specification No. 61-01, Sheet No. 52, 7 March 1961, (HLM 9.64)]. FS Date: 7/13/2021

Top of bridge.

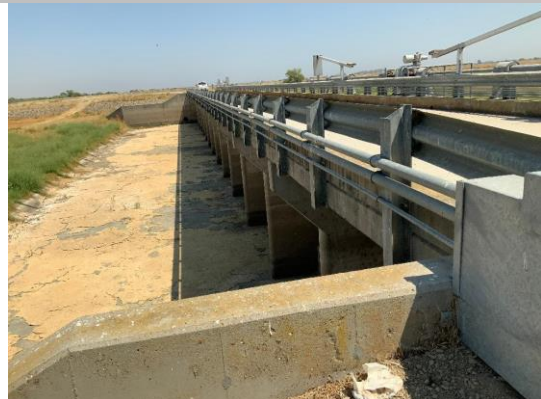
Photo 2 of 3 : UCIP_SP_2022_71159_102278.jpg

LS view: Inlet culverts along bridge at toe.

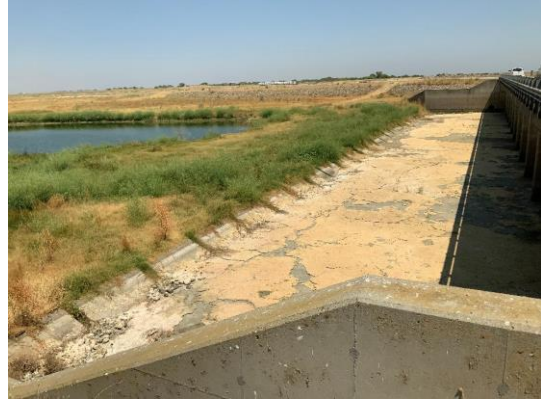
Photo 3 of 3 : UCIP_SP_2022_71159_102279.jpg

LS view: Slope from crown.

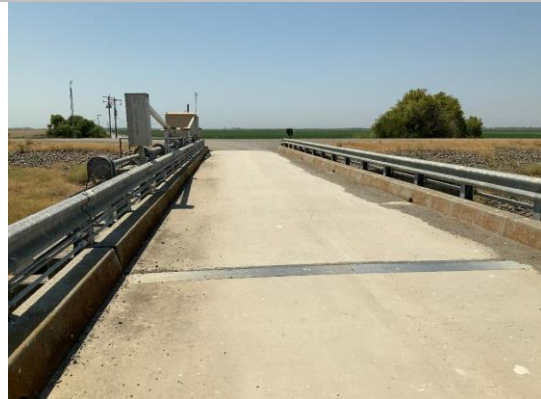
Photo 1 of 3 : UCIP_SP_2022_71160_102282.jpg

FS_ID:71160
DS_ID:19739
EP_NO: N/A
Repair Type: Non-Urgent
Crossing Status: Found
UCIP Comments: 07/13/2021 The record remains Non-Urgent. No permit was found authorizing this encroachment. CVFPB will need to review crossing to determine owner. Crossing appears in good condition. The UCIP inspection was completed with GEI staff, P. Espinoza. (H. Dunn ? GEI) 10/27/2017 This structure is inspected annually under the Structure and Channel Summer Inspection (part of the Levee Inspection Program) conducted by the DWR Flood Project Integrity and Inspection Branch (FPIIB). (O. Magana - DWR UCIP) 04/21/2014 Accidentally missed--need photos. (O. Magana - DWR UCIP)
FIELD_STRUCT_DESC: [Mariposa Bypass Control Structure] 2 of 5: Approximately 14 reinforced concrete box gravity drainage culverts (RCBC) of an unknown size across the intersection of the Mariposa Bypass and the Eastside Bypass. Roadway across structure. Controlled slide gates on end four culverts, both sides. Wing wall on each side of the structure. Rock revetment immediately downstream of the structure. [Additional Reference(s): DWR Levee Log, 2002, (HLM 9.64). USACE San Joaquin O&M Manual, Unit No. 601, Part No. 1, 1967, Amended in 1978, Revised 20 June 1985, (HLM 9.64). DWR As-Built Specification No. 61-01, Sheet No. 52, 7 March 1961, (HLM 9.64)].

Top of bridge.

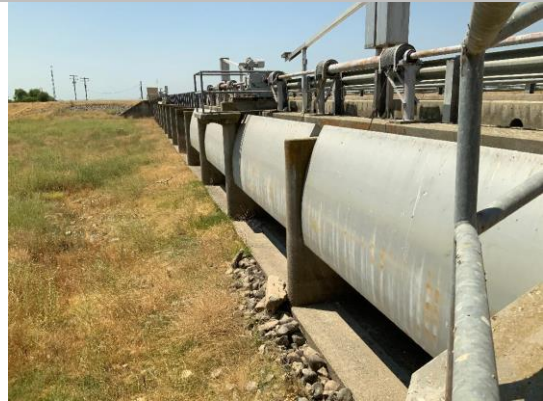
Photo 2 of 3 : UCIP_SP_2022_71160_102283.jpg

LS view: Slidegates along bridge at toe.

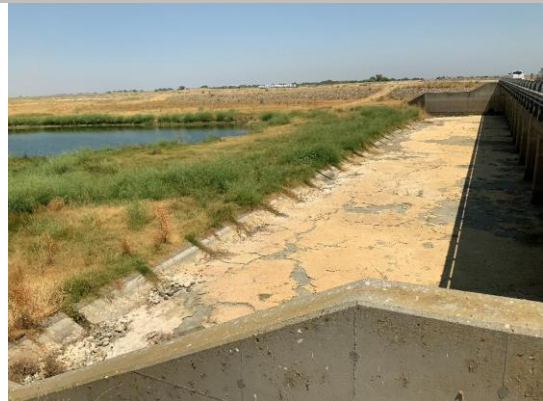
Photo 3 of 3 : UCIP_SP_2022_71160_102285.jpg

LS view: Slope from crown.
