**Flood Control Project Maintenance
Levee Inspections
LMA District Cover Sheet**

Lower San Joaquin Levee District

**Flood Control Project Maintenance
Levee Inspections
Unit Cover Sheet**

Levee Inspection Report By Mile - Spring 2022

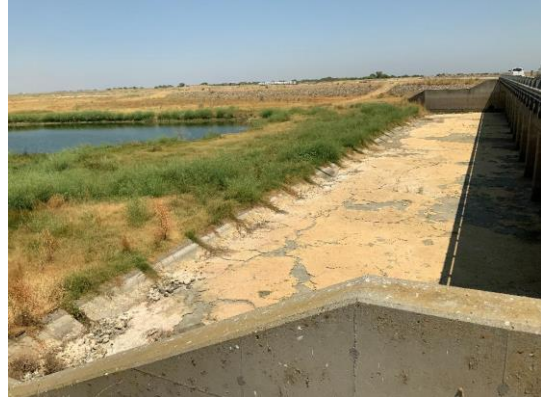
Photo 3 of 3 : UCIP_SP_2022_71162_102293.jpg

Comment Code					
Inspector Comment					
FS_ID:71162 DS_ID:19740 EP_NO: N/A Repair Type: Non-Urgent Crossing Status: Found UCIP Comments: 07/13/2021 The record remains Non-Urgent. No permit was found authorizing this encroachment. CVFPB will need to review crossing to determine owner. Crossing appears in good condition. The UCIP inspection was completed with GEI staff, P. Espinoza. (H. Dunn ? GEI) 10/27/2017 This structure is inspected annually under the Structure and Channel Summer Inspection (part of the Levee Inspection Program) conducted by the DWR Flood Project Integrity and Inspection Branch (FPIIB). (DWR UCIP - O. Magana) 04/21/2014 Accidentally missed--need photos (DWR UCIP - O. Magana) FIELD_STRUCT_DESC: [Mariposa Bypass Control Structure] 3 of 5: Approximately 14 reinforced concrete box gravity drainage culverts (RCBC) of an unknown size across the intersection of the Mariposa Bypass and the Eastside Bypass. Roadway across structure. Controlled slide gates on end four culverts, both sides. Wing wall on each side of the structure. Rock revetment immediately downstream of the structure. [Additional Reference(s): DWR Levee Log, 2002, (HLM 9.64). USACE San Joaquin O&M Manual, Unit No. 601, Part No. 1, 1967, Amended in 1978, Revised 20 June 1985, (HLM 9.64). DWR As-Built Specification No. 61-01, Sheet No. 52, 7 March 1961, (HLM 9.64)]. FS Date: 7/13/2021

LS view: Slope from crown.

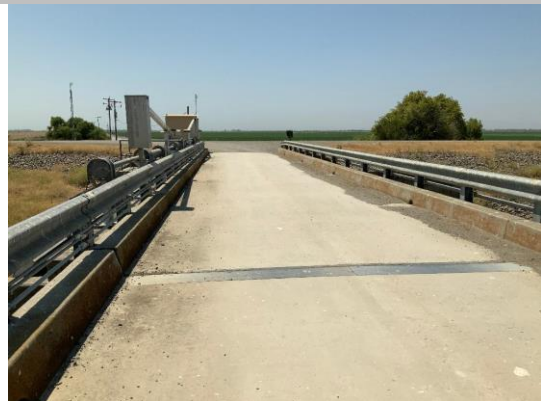
Photo 1 of 3 : UCIP_SP_2022_71163_102296.jpg

FS_ID:71163
DS_ID:19741
EP_NO: N/A
Repair Type: Non-Urgent
Crossing Status: Found
UCIP Comments: 07/13/2021 The record remains Non-Urgent. No permit was found authorizing this encroachment. CVFPB will need to review crossing to determine owner. Crossing appears in good condition. The UCIP inspection was completed with GEI staff, P. Espinoza. (H. Dunn ? GEI) 10/27/2017 This structure is inspected annually under the Structure and Channel Summer Inspection (part of the Levee Inspection Program) conducted by the DWR Flood Project Integrity and Inspection Branch (FPIIB). (DWR UCIP - O. Magana) 04/21/2014 Accidentally missed--need photos (DWR UCIP - O. Magana) FIELD_STRUCT_DESC: [Mariposa Bypass Control Structure] 4 of 5: Approximately 14 reinforced concrete box gravity drainage culverts (RCBC) of an unknown size across the intersection of the Mariposa Bypass and the Eastside Bypass. Roadway across structure. Controlled slide gates on end four culverts, both sides. Wing wall on each side of the structure. Rock revetment immediately downstream of the structure. [Additional Reference(s): DWR Levee Log, 2002, (HLM 9.64). USACE San Joaquin O&M Manual, Unit No. 601, Part No. 1, 1967, Amended in 1978, Revised 20 June 1985, (HLM 9.64). DWR As-Built Specification No. 61-01, Sheet No. 52, 7 March 1961, (HLM 9.64)].

Top of bridge.

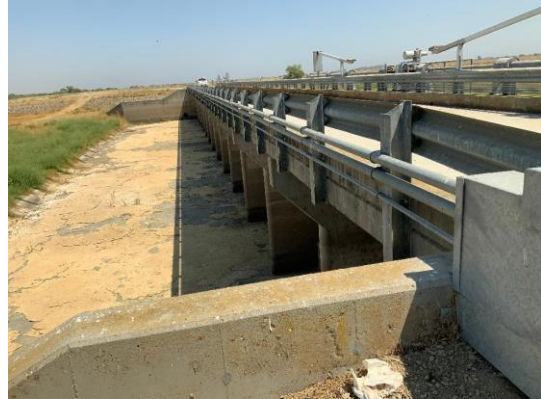
Photo 2 of 3 : UCIP_SP_2022_71163_102297.jpg

LS view: Inlet culverts along bridge at toe.

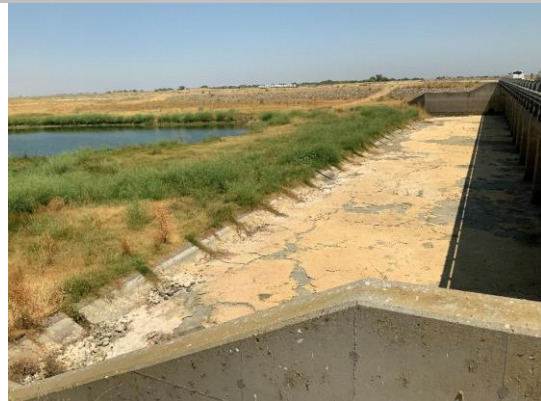
Photo 3 of 3 : UCIP_SP_2022_71163_102298.jpg

LS view: Slope from crown.

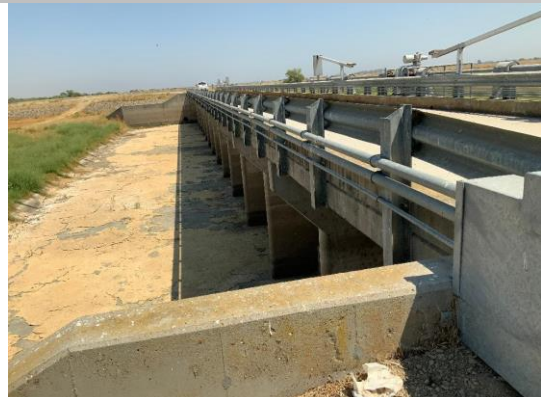
Photo 2 of 3 : UCIP_SP_2022_71164_102302.jpg

Comment Code						
Inspector Comment						
FS_ID:71164 DS_ID:19558 EP_NO: N/A Repair Type: Non-Urgent Crossing Status: Found UCIP Comments: 07/13/2021 The record remains Non-Urgent. No permit was found authorizing this encroachment. CVFPB will need to review crossing to determine owner. Crossing appears in good condition. The UCIP inspection was completed with GEI staff, P. Espinoza. (H. Dunn ? GEI) 10/27/2017 This structure is inspected annually under the Structure and Channel Summer Inspection (part of the Levee Inspection Program) conducted by the DWR Flood Project Integrity and Inspection Branch (FPIIB). (DWR UCIP - O. Magana) 04/21/2014 Accidentally missed--need photos (DWR UCIP - O. Magana) FIELD_STRUCT_DESC: [Mariposa Bypass Control Structure] 5 of 5: Approximately 14 reinforced concrete box gravity drainage culverts (RCBC) of an unknown size across the intersection of the Mariposa Bypass and the Eastside Bypass. Roadway across structure. Controlled slide gates on end four culverts, both sides. Wing wall on each side of the structure. Rock revetment immediately downstream of the structure. [Additional Reference(s): DWR Levee Log, 2002, (HLM 9.64). USACE San Joaquin O&M Manual, Unit No. 601, Part No. 1, 1967, Amended in 1978, Revised 20 June 1985, (HLM 9.64). DWR As-Built Specification No. 61-01, Sheet No. 52, 7 March 1961, (HLM 9.64)]. FS Date: 7/13/2021

LS view: Inlet culverts along bridge at toe.

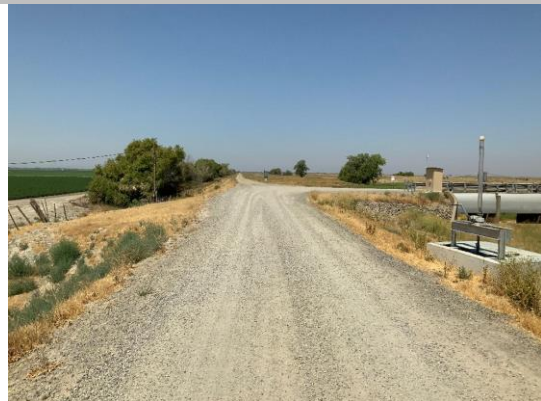
Photo 1 of 3 : UCIP_SP_2022_71126_101564.jpg

FS_ID:71126
DS_ID:25540
EP_NO: 18961
Repair Type: Non-Urgent
Crossing Status: Found
UCIP Comments: 07/12/2021 The record is Non-Urgent. Could not inspect LS due to barbed wire and pipe inlets being underwater. Crossing is new since the last inspection and has replaced the pipe for DSID 19874. Crossing appears in good condition. The UCIP inspection was completed with GEI staff, P. Espinoza. (H. Dunn ? GEI)

Levee crown.

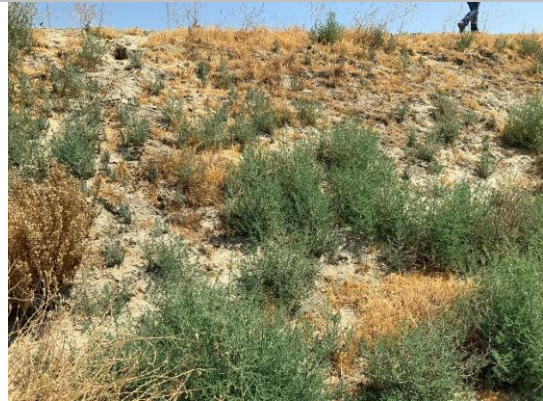
Photo 2 of 3 : UCIP_SP_2022_71126_101565.jpg

LS view: Slope from toe.

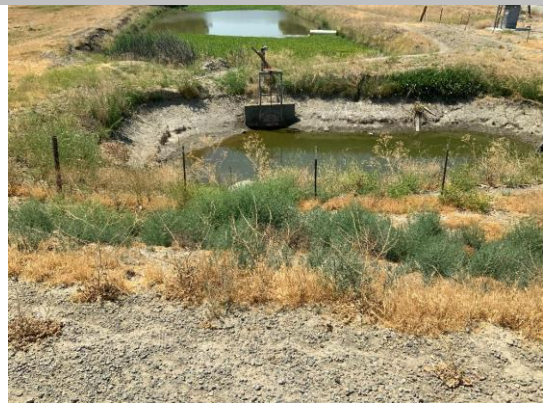
Photo 3 of 3 : UCIP_SP_2022_71126_101568.jpg

LS view: Toe from crown.

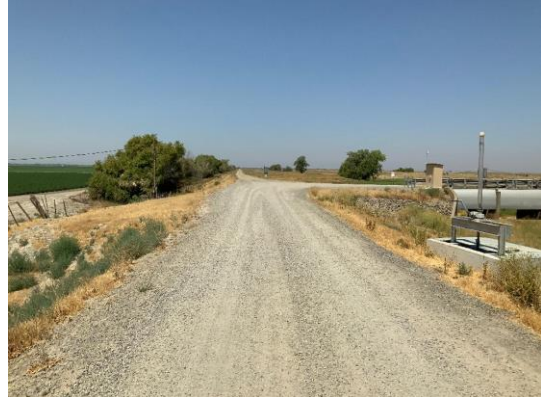
Photo 1 of 3 : UCIP_SP_2022_71127_102306.jpg

Comment Code						
Inspector Comment						
FS_ID:71127						
DS_ID:25541						
EP_NO: 18961						
Repair Type: Non-Urgent						
Crossing Status: Found						
UCIP Comments: 07/13/2021 The record is Non-Urgent. Crossing is new since the last inspection and has replaced the pipe for DSID 19874. Limited inspection of LS pipe inlet due to standing water and barbed wire. The UCIP inspection was completed with GEI staff, P. Espinoza. (H. Dunn ? GEI) 09/23/2020 UCIP record brought online. (O. Magana - DWR UCIP)						
FIELD_STRUCT_DESC: [Eastside Bypass Siphon] 2 of 2: 54-inch rubber gasket reinforced concrete pipe (RGRCP) siphon through the levee, at an unknown depth. Siphon goes through the Unit 5 levee, under the channel, and through the Unit 6 levee. Inlet structure and pump station on the north side of Unit 5. Concrete standpipes (siphons) in the channel. Screw gates on the north side of Unit 6. Electrical box on the crown of the Unit 6 levee. (Two 54-inch siphons authorized under Permit No. 18961, 2016 - Henry Miller Reclamation District. Existing 48-inch siphon was removed).

Levee crown.

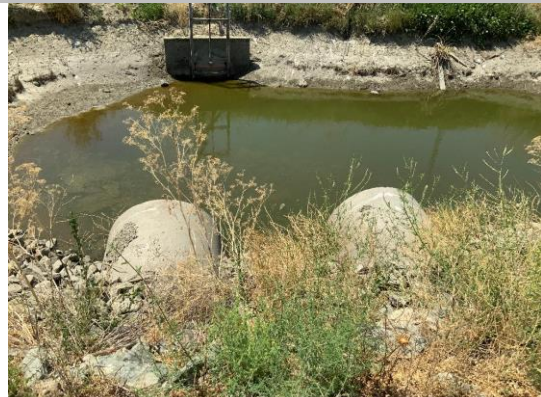
Photo 2 of 3 : UCIP_SP_2022_71127_102313.jpg

LS view: Closeup of pipe inlets at toe under water.

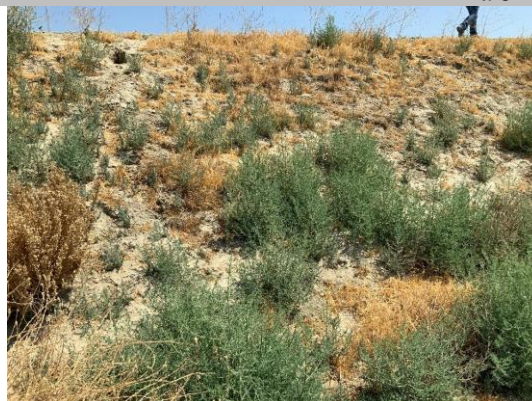
Photo 3 of 3 : UCIP_SP_2022_71127_102307.jpg

LS view: Slope from toe.

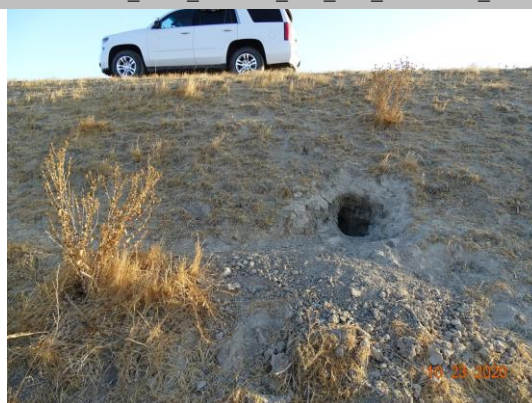
Photo 1 of 1 : SP_2022_NA0010_124_102_20220308_00031.jpg

LM Start	10.12	Rating **	U	Issue No.	102
LM End	10.12	Issue Type +	Ma	Location *	LS
Category	Earthen Levee			GPS Latitude/Longitude	
				Start	End
Item	Animal Control			37.196845 °	37.196845 °
				-120.687892 °	-120.687892 °
DWR ID	DWR_NA0010_06_f_2020_102				
Comment Code					
A3 : No rodents visible, but rodent burrows visible; need to backfill and compact or grout burrows.					
Inspector Comment

View of large animal burrow in the landside slope. (Fall 2020)

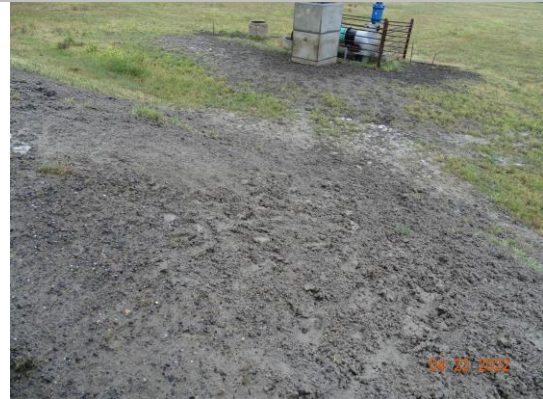
Photo 1 of 1 : SP_2022_NA0010_124_141_20220425_00235.jpg

LM Start	10.96	Rating **	A/W	Issue No.	141
LM End	10.96	Issue Type +	Ma	Location *	LS
Category	Earthen Levee			GPS Latitude/Longitude	
				Start	End
Item	Erosion / Livestock			37.187999 °	37.187999 °
				-120.677522 °	-120.677522 °
DWR ID	DWR_NA0010_06_s_2022_141				
Comment Code					
E4 : Repair the levee slope damaged by livestock and prevent large animal access.					
Inspector Comment

View of damage to the landside slope. (Spring 2022)

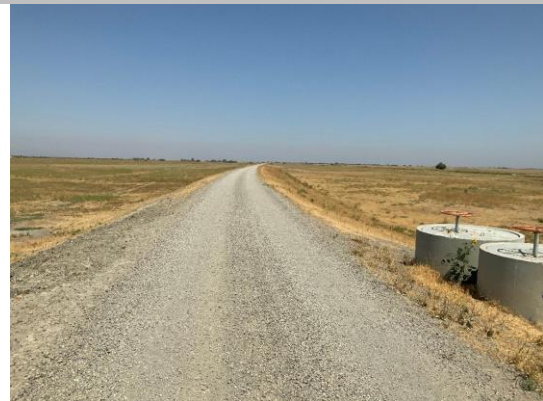
Photo 1 of 3 : UCIP_SP_2022_71128_102318.jpg

Comment Code						
Inspector Comment						
FS_ID:71128 DS_ID:19563 EP_NO: 18624 Repair Type: Non-Urgent Crossing Status: Found UCIP Comments: 07/13/2021 The record has been upgraded from No Action Needed to Non-Urgent. WS outlets were underwater at time of inspection, limited inspection. There appears to be a new pump and pipe system off the LS toe. Confirm with owner on the status of this crossing. The UCIP inspection was completed with GEI staff, P. Espinoza. (H. Dunn ? GEI) FIELD_STRUCT_DESC: 36-inch reinforced concrete water supply pipe (RCP) through the levee, 5.0 feet below the crown. Pipe riser units on both the inlet and the outlet sides. Control gate on the landside (LS). Slide gate on the waterside (WS) end. Joints secured in hoop steel and encased in concrete at each levee toe. (36-inch water pipe authorized under Permit No. 18624, 2010 - Wolfsen Land and Cattle Company). FS Date: 7/13/2021

Levee crown.

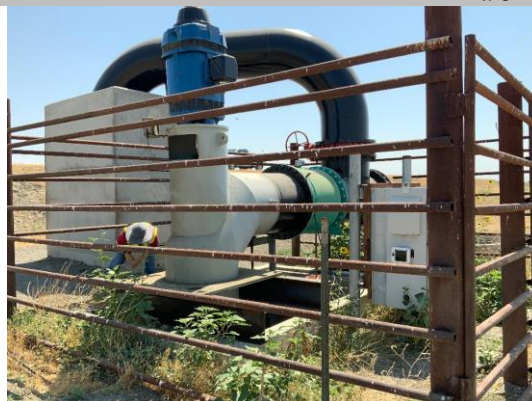
Photo 2 of 3 : UCIP_SP_2022_71128_102319.jpg

LS view: New pump and pipe system off the toe.

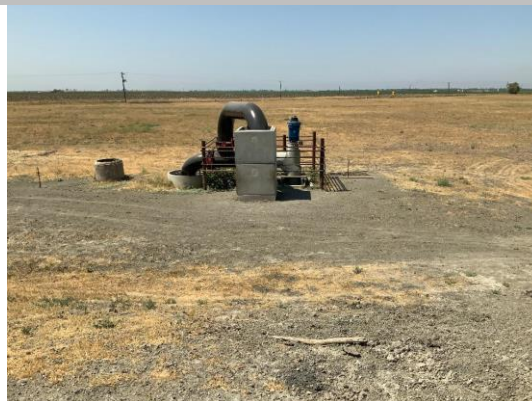
Photo 3 of 3 : UCIP_SP_2022_71128_102316.jpg

LS view: New pumps and pipe system off toe.

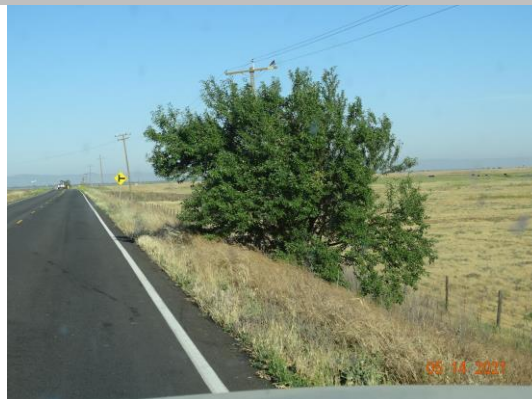
Photo 1 of 1 : SP_2022_NA0010_124_14_20220308_00003.jpg

LM Start	11.49	Rating **	M	Issue No.	14
LM End	11.49	Issue Type +	Ma	Location *	WS
Category	Earthen Levee			GPS Latitude/Longitude	
				Start	End
Item	Trim / Thin Trees			37.186189 °	37.186189 °
				-120.668476 °	-120.668476 °
DWR ID	DWR_NA0010_06_s_2015_14				
Comment Code					
T1 : Trim and thin trees to at least five feet above ground level to allow visibility of the ground and room to flood fight.					
Inspector Comment					
Almond tree located along Sandy Mush Road on waterside slope.

Looking west at tree on waterward slope. (Spring 2021)

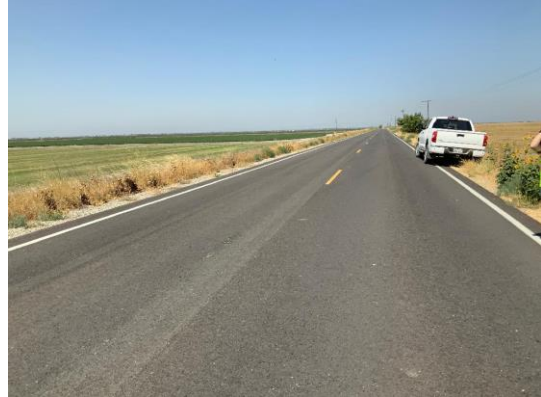
Photo 1 of 3 : UCIP_SP_2022_71150_102321.jpg

Comment Code						
Inspector Comment						
FS_ID:71150 DS_ID:19875 EP_NO: N/A Repair Type: Non-Urgent Crossing Status: Indicator Found UCIP Comments: 07/13/2021 The record remains Non-Urgent. Limited inspection due to dense vegetation over both LS inlet/headwall and WS flapgate, recommend removal of vegetation on both ends. WS toe is also covered by barbed wire. No permit was found authorizing this encroachment. CVFPB will need to review crossing to determine owner. The UCIP inspection was completed with GEI staff, P. Espinoza. (H. Dunn ? GEI) 04/17/2014 Unable to stop--high traffic area--safety issue. Crossing needs to be evaluated. (O. Magana - DWR UCIP) FIELD_STRUCT_DESC: 24-inch corrugated metal gravity drainage pipe (CMP) through the levee, 16.6 feet below the crown. Flap gate on the waterside (WS) end. [Additional Reference(s): DWR Levee Log, 2002, (HLM 11.65). USACE San Joaquin O&M Manual, Unit No. 601, Part No. 1, 1967, Amended in 1978, Revised 20 June 1985, (HLM 11.64). DWR As-Built Specification No. 59-01, Sheet No. 66, 10 December 1958, (HLM 11.64)]. FS Date: 7/13/2021

Levee crown.

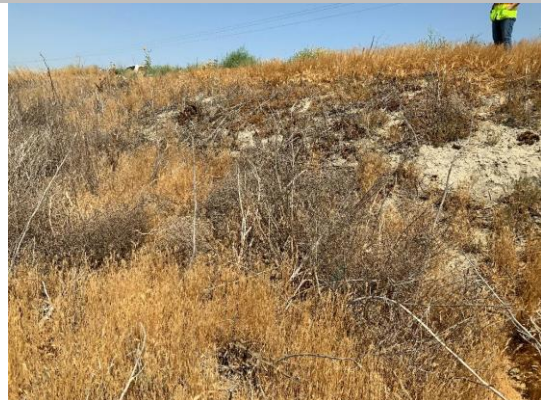
Photo 2 of 3 : UCIP_SP_2022_71150_102325.jpg

LS view: Slope from toe.

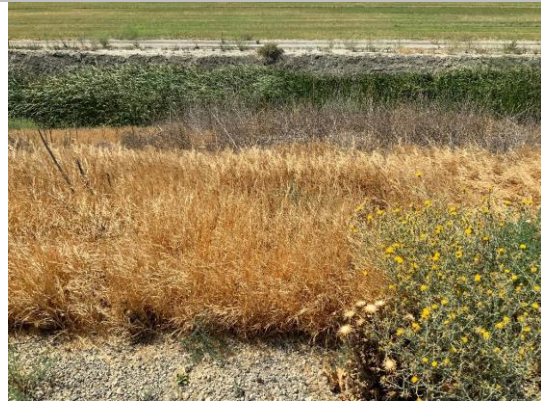
Photo 3 of 3 : UCIP_SP_2022_71150_102324.jpg

LS view: Toe from crown.

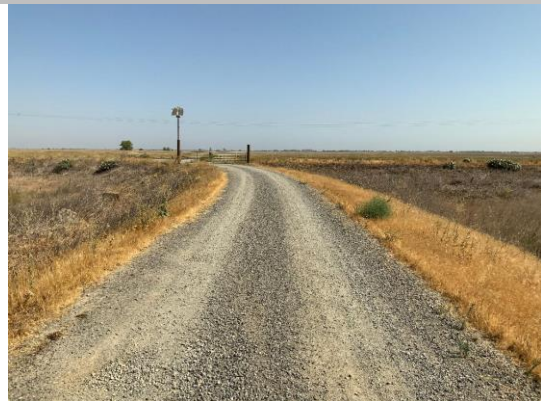
Photo 1 of 3 : UCIP_SP_2022_71151_102330.jpg

FS_ID:71151
 DS_ID:19876
 EP_NO: N/A
 Repair Type: Non-Urgent
 Crossing Status: Found
 UCIP Comments: 07/13/2021 The record remains Non-Urgent. Dense vegetation over LS inlet and WS outlet, recommend removal of vegetation from both sides. Limited inspection of both inlet and outlet. No permit was found authorizing this encroachment. CVFPB will need to review crossing to determine owner. The UCIP inspection was completed with GEI staff, P. Espinoza. (H. Dunn ? GEI) 04/17/2014 Clear debris from waterward and landward toes. (O. Magana - DWR UCIP)
 FIELD_STRUCT_DESC: 36-inch corrugated metal gravity drainage pipe (CMP) through the levee, 17.0 feet below the crown. Slide gate in a pipe riser unit on the waterside (WS) slope. [Additional Reference(s): DWR Levee Log, 2002, (HLM 11.83). USACE San Joaquin O&M Manual, Unit No. 601, Part No. 1, 1967, Amended in 1978, Revised 20 June 1985, (HLM 11.82). DWR As-Built Specification No. 59-01, Sheet No. 66, 10 December 1958, (HLM 11.82)].

Levee crown.

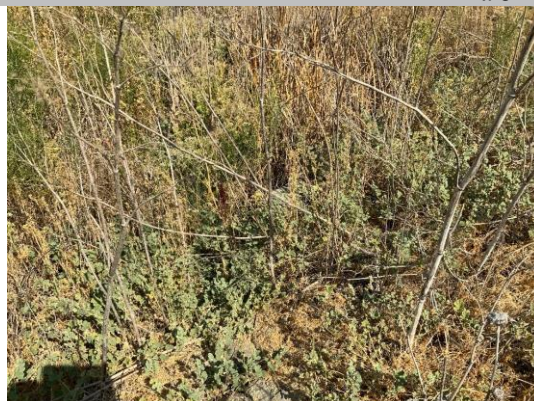
Photo 2 of 3 : UCIP_SP_2022_71151_102328.jpg

WS view: Flapgate barely visible under dense vegetation at toe.

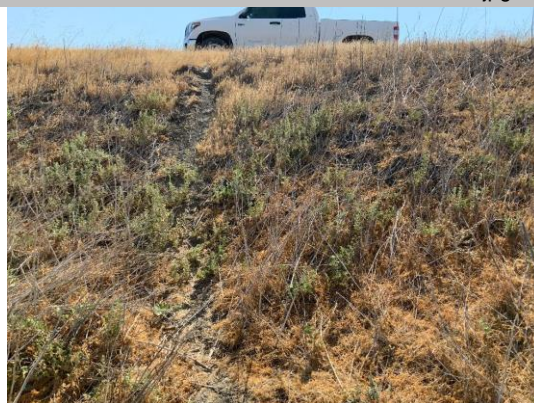
Photo 3 of 3 : UCIP_SP_2022_71151_102329.jpg

LS view: Slope from toe.

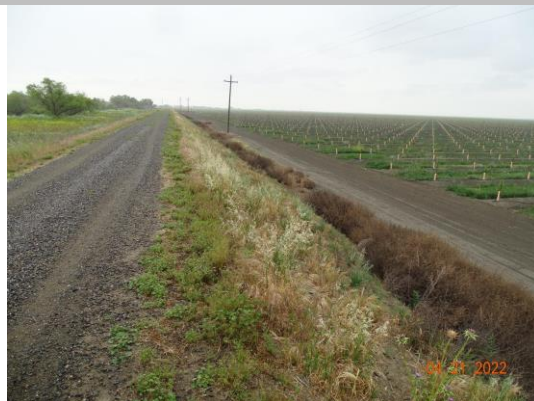
Photo 1 of 1 : SP_2022_NA0010_124_139_20220425_00236.jpg

LM Start	11.76	Rating **	M	Issue No.	139
LM End	13.06	Issue Type +	Ma	Location *	LS
Category	Earthen Levee			GPS Latitude/Longitude	
				Start	End
Item	Vegetation			37.185221 °	37.171704 °
				-120.664567 °	-120.657939 °
DWR ID	DWR_NA0010_06_s_2022_139				
Comment Code					
V1 : Control annual grass and weeds on the levee slopes and easements.					
Inspector Comment

Looking upstream along the landside slope. (Spring 2022)

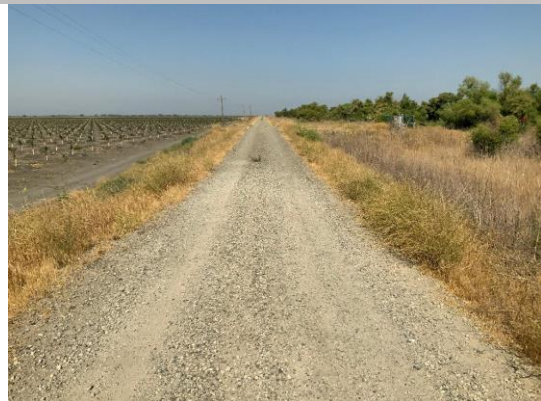
Photo 1 of 3 : UCIP_SP_2022_71152_102335.jpg

Comment Code					
Inspector Comment					
FS_ID:71152 DS_ID:19877 EP_NO: N/A Repair Type: Non-Urgent Crossing Status: Found UCIP Comments: 07/13/2021 The record remains Non-Urgent. Partial cover on WS riser, recommend repair for safety reasons. Limited inspection due to LS pipe inlet being overed with vegetation, headwall barely visible, recommend removal. WS outlet not found, possibly buried under dirt or vegetaion. Recommend removal of vegetation and dirt to uncover WS pipe outlet. No permit was found authorizing this encroachment. CVFPB will need to review crossing to determine owner. The UCIP inspection was completed with GEI staff, P. Espinoza. (H. Dunn ? GEI) 04/17/2014 Not accessible--crossing is buried on landward side. Need to contact owner to determine status. (O. Magana - DWR UCIP) FIELD_STRUCT_DESC: 24-inch corrugated metal gravity drainage pipe (CMP) through the levee, 10.8 feet below the crown. Flap gate on the waterside (WS) end. [Additional Reference(s): DWR Levee Log, 2002, (HLM 13.31). USACE San Joaquin O&M Manual, Unit No. 601, Part No. 1, 1967, Amended in 1978, Revised 20 June 1985, (HLM 13.30). DWR As-Built Specification No. 59-01, Sheet No. 67, 10 December 1958, (HLM 13.30)]. FS Date: 7/13/2021

Levee crown.

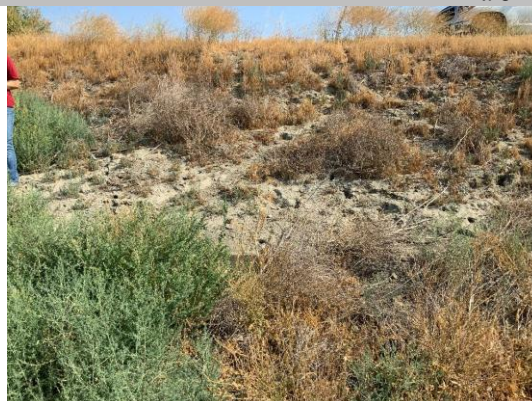
Photo 2 of 3 : UCIP_SP_2022_71152_102334.jpg

LS view: Slope from toe.

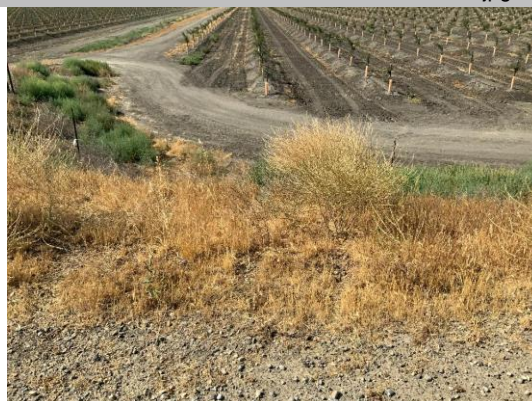
Photo 3 of 3 : UCIP_SP_2022_71152_102339.jpg

LS view: Toe from crown.

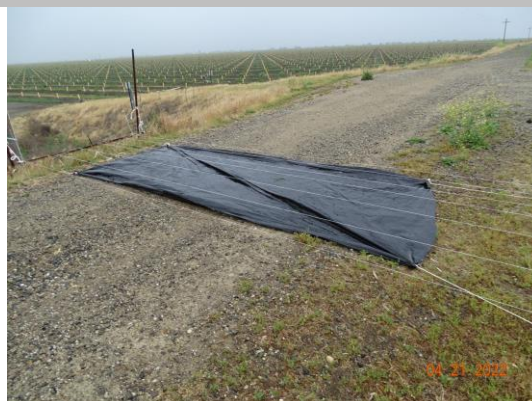
Photo 1 of 1 : SP_2022_NA0010_124_138_20220429_00237.jpg

LM Start	13.23	Rating **	M	Issue No.	138
LM End	13.23	Issue Type +	En	Location *	CR
Category	Earthen Levee			GPS Latitude/Longitude	
				Start	End
Item	Encroachments			37.171713 °	37.171713 °
				-120.654822 °	-120.654822 °
DWR ID	DWR_NA0010_06_s_2022_138				
Comment Code					
FE : Fence					
Inspector Comment					
temporary livestock fence installed across the levee crown.

View of temporary fence installed across the levee crown. (Spring 2022)

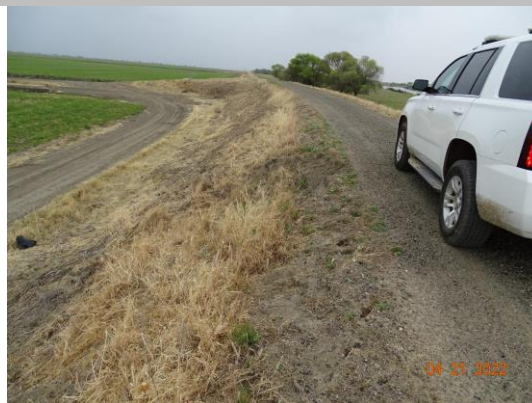
Photo 1 of 1 : SP_2022_NA0010_124_120_20220429_00238.jpg

LM Start	14.00	Rating **	U	Issue No.	120
LM End	14.00	Issue Type +	Ma	Location *	LS
Category	Earthen Levee			GPS Latitude/Longitude	
				Start	End
Item	Slope Stability			37.171591 °	37.171591 °
				-120.640938 °	-120.640938 °
DWR ID	DWR_NA0010_06_f_2021_120				
Comment Code					
S1 : Repair slope instability.					
Inspector Comment					
Caving has eaten approximately 1 foot into the levee crown.

View of slope stability issue on the landside slope. (Spring 2022)

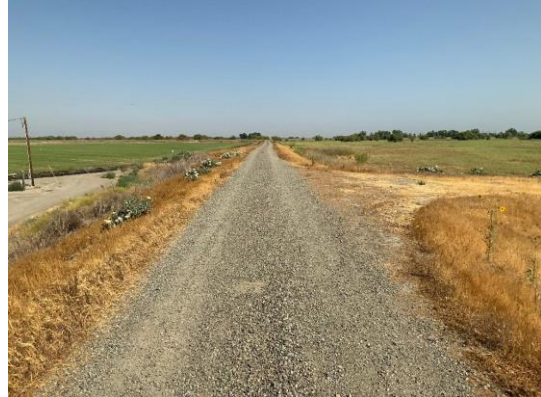
Photo 1 of 3 : UCIP_SP_2022_71153_102392.jpg

FS_ID:71153
DS_ID:19878
EP_NO: N/A
Repair Type: Non-Urgent
Crossing Status: Found
UCIP Comments: 07/13/2021 The record remains Non-Urgent. Limited inspection due to LS pipe inlet not being found, assuming its completely buried. Recommend removing dirt and vegetation to find alignment and confirming with owner on the status of this pipe. No permit was found authorizing this encroachment. CVFPB will need to review crossing to determine owner. The UCIP inspection was completed with GEI staff, P. Espinoza. (H. Dunn ? GEI) 04/17/2014 Not accessible--crossing is buried on landward side. Need to contact owner to determine status. (O. Magana - DWR UCIP)
FIELD_STRUCT_DESC: 24-inch corrugated metal gravity drainage pipe (CMP) through the levee, 12.3 feet below the crown. Flap gate on the waterside (WS) end. [Additional Reference(s): DWR Levee Log, 2002 (HLM 14.45). USACE San Joaquin O&M Manual, Unit No. 601, Part No. 1, 1967, Amended in 1978, Revised 20 June 1985, (HLM 14.44). DWR As-Built Specification No. 59-01, Sheet No. 68, 10 December 1958, (HLM 14.44)].

Levee crown.

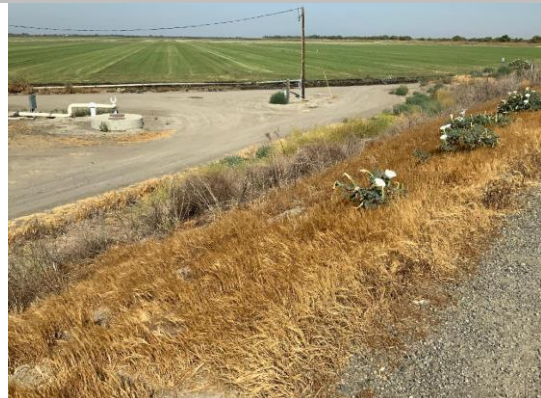
Photo 2 of 3 : UCIP_SP_2022_71153_102396.jpg

LS view: Slope from crown, no pipe visible.

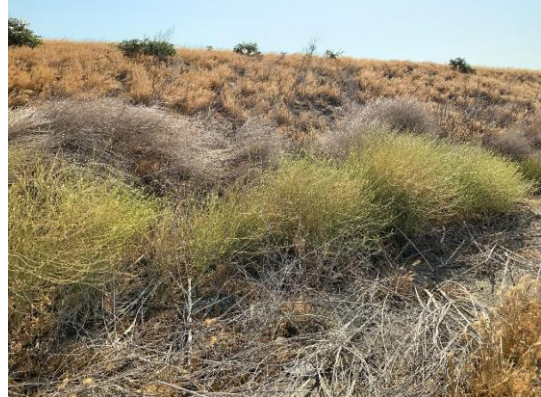
Photo 3 of 3 : UCIP_SP_2022_71153_102397.jpg

LS view: Slope from toe, no pipe visible.

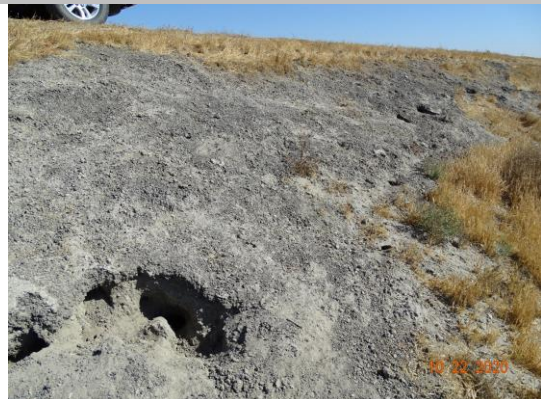
LM Start	14.37	Rating **	A/W	Issue No.	98
LM End	14.37	Issue Type +	Ma	Location *	WS
Category	Earthen Levee			GPS Latitude/Longitude	
				Start	End
Item	Animal Control			37.167740 °	37.167740 °
				-120.636282 °	-120.636282 °
DWR ID	DWR_NA0010_06_f _ 2020_98				
Comment Code					
A3 : No rodents visible, but rodent burrows visible; need to backfill and compact or grout burrows.					
Inspector Comment

Looking upstream along the waterside slope. (Fall 2020)

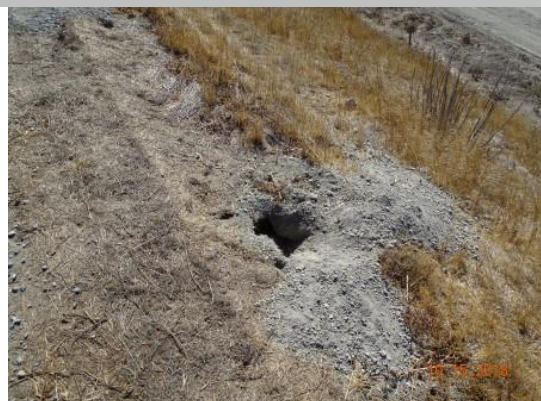
LM Start	14.63	Rating **	A/W	Issue No.	101
LM End	14.64	Issue Type +	Ma	Location *	LS
Category	Earthen Levee			GPS Latitude/Longitude	
				Start	End
Item	Animal Control			37.164871 °	37.164824 °
				-120.633222 °	-120.633167 °
DWR ID	DWR_NA0010_06_f _ 2018_101				
Comment Code					
A3 : No rodents visible, but rodent burrows visible; need to backfill and compact or grout burrows.					
Inspector Comment					
Burrows are located along landside shoulder.

View of rodent hole on landside shoulder. (Fall 2018)

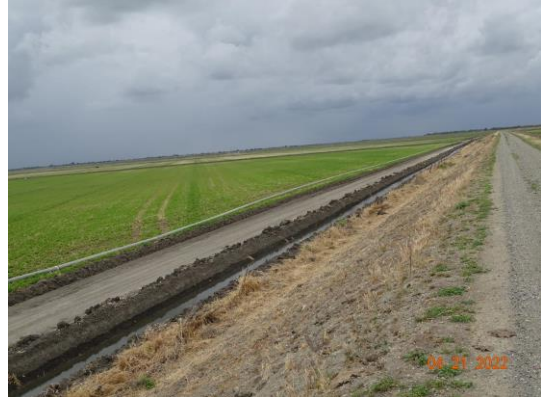
LM Start	14.71	Rating **	M	Issue No.	119
LM End	15.23	Issue Type +	En	Location *	LS
Category	Earthen Levee			GPS Latitude/Longitude	
				Start	End
Item	Encroachments			37.164000 °	37.160390 °
				-120.632225 °	-120.623995 °
DWR ID	DWR_NA0010_06_f_2021_119				
Comment Code					
DT : Ditch					
Inspector Comment					
Ditch dug approximate 5 - 15 feet from the landside toe.

Ditch landowner has dug on the landside toe. (Spring 2022)

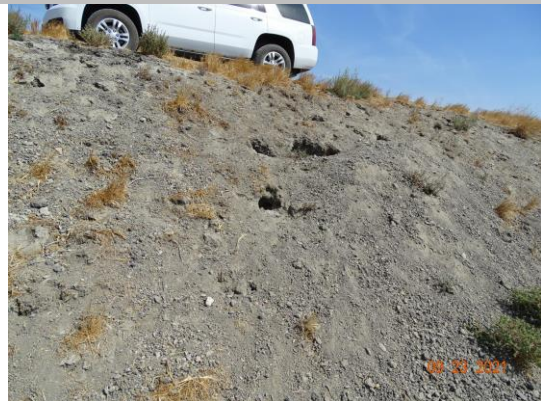
LM Start	15.31	Rating **	U	Issue No.	124
LM End	15.70	Issue Type +	Ma	Location *	LS
Category	Earthen Levee			GPS Latitude/Longitude	
				Start	End
Item	Animal Control			37.159932 °	37.157217 °
				-120.622810 °	-120.618915 °
DWR ID	DWR_NA0010_06_s_2012_124				
Comment Code					
A1 : Exterminate rodents and backfill and compact or grout burrows.					
Inspector Comment

Large rodent burrows observed in the landside slope. (Fall 2021)

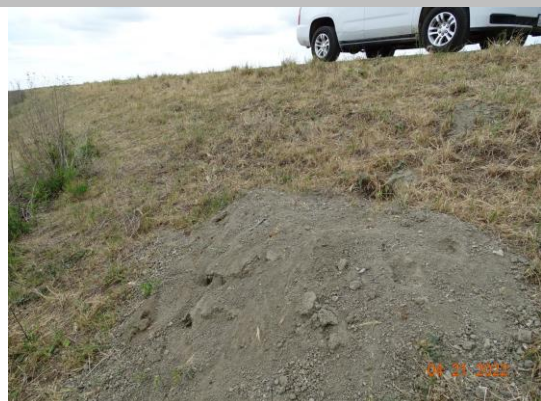
LM Start	15.32	Rating **	M	Issue No.	118
LM End	15.32	Issue Type +	Ma	Location *	WS
Category	Earthen Levee			GPS Latitude/Longitude	
				Start	End
Item	Animal Control			37.159815 °	37.159815 °
				-120.622513 °	-120.622513 °
DWR ID	DWR_NA0010_06_s_2022_118				
Comment Code					
A1 : Exterminate rodents and backfill and compact or grout burrows.					
Inspector Comment

View of rodent holes on the waterside slope. (Spring 2022)

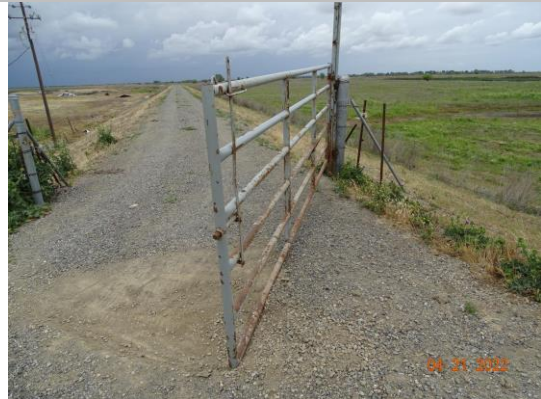
LM Start	15.66	Rating **	M	Issue No.	137
LM End	15.66	Issue Type +	Ma	Location *	CR
Category	Earthen Levee			GPS Latitude/Longitude	
				Start	End
Item	Access Gates			37.157108 °	37.157108 °
				-120.617451 °	-120.617451 °
DWR ID	DWR_NA0010_06_s_2022_137				
Comment Code					
Inspector Comment					
New gate installed does not have enough clearance above the levee crown to fully open. This a possible access issue for larger vehicles. Recommend reinstalling or replacing.

View of access gate that cannot fully open and is damaging the levee crown. (Spring 2022)

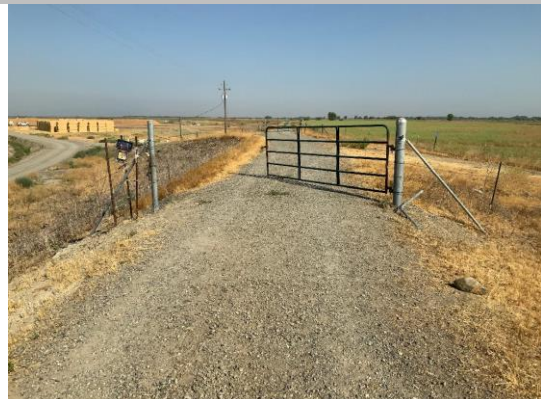
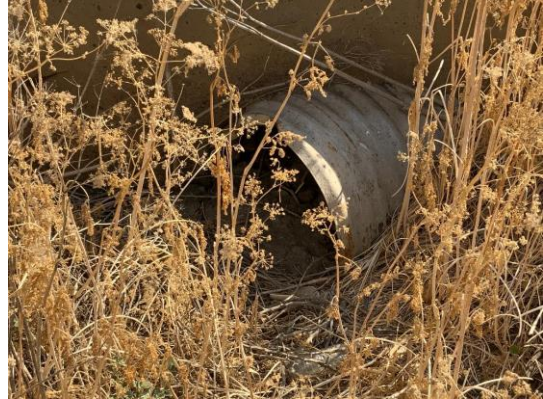
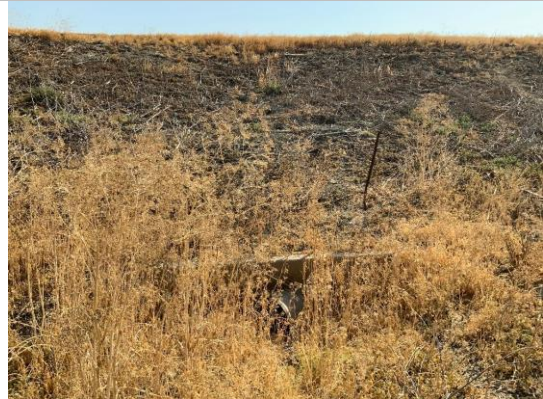
Comment Code					
Inspector Comment					
FS_ID:71133 DS_ID:19884 EP_NO: N/A Repair Type: Non-Urgent Crossing Status: Found UCIP Comments: 07/13/2021 The record remains Non-Urgent. Limited inspection of LS pipe inlet. LS pipe edges are warped and inlet filled with sediment and some vegetation, recommend cleaning out. No permit was found authorizing this encroachment. CVFPB will need to review crossing to determine owner. The UCIP inspection was completed with GEI staff, P. Espinoza. (H. Dunn ? GEI) 04/17/2014 Need to contact owner. Sediment buildup on both the waterward and landward side. Recommend removing sediment buildup from both side. Also recommend clearing excess sediment inside crossing. (O. Magana - DWR UCIP) FIELD_STRUCT_DESC: 24-inch corrugated metal gravity drainage pipe (CMP) through the levee, 14.0 feet below the crown. Flap gate on the waterside (WS) end. [Additional Reference(s): DWR Levee Log, 2002, (HLM 15.78). USACE San Joaquin O&M Manual, Unit No. 601, Part No. 1, 1967, Amended in 1978, Revised 20 June 1985, (HLM 15.76). DWR As-Built Specification No. 59-01, Sheet No. 69, 10 December 1958, (HLM 15.76)]. FS Date: 7/13/2021

LS view: Closeup of pipe inlet at toe with sediment buildup.

LS view: Headwall visible at toe.

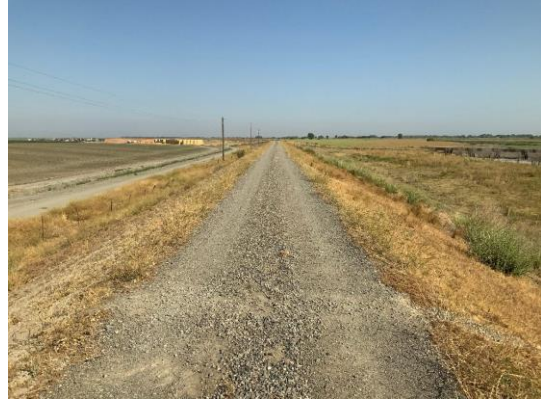
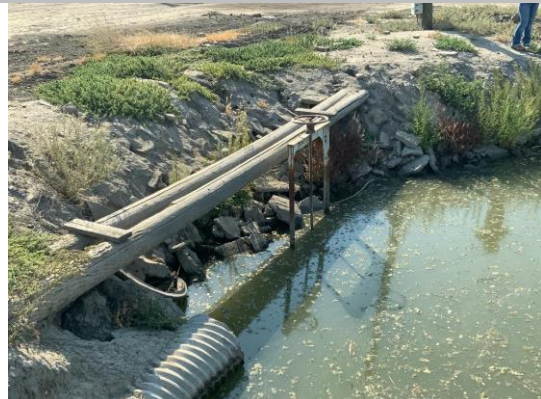
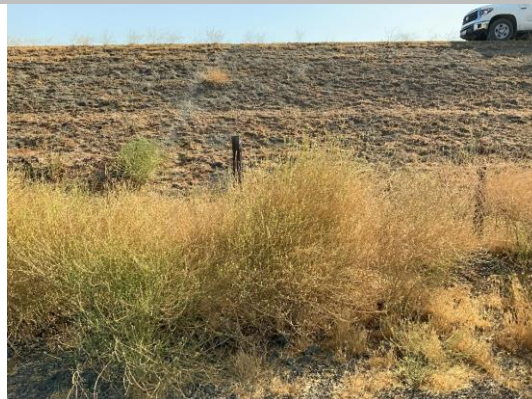
Comment Code						
Inspector Comment						
FS_ID:71134 DS_ID:19885 EP_NO: N/A Repair Type: Non-Urgent Crossing Status: Found UCIP Comments: 07/13/2021 The record remains Non-Urgent. LS pipe inlet was underwater at time of inspection. WS flapgate was buried under sediment, limited inspection on both ends. Recommend removal of sediment covering flapgate on WS. No permit was found authorizing this encroachment. CVFPB will need to review crossing to determine owner. The UCIP inspection was completed with GEI staff, P. Espinoza. (H. Dunn ? GEI) 04/17/2014 Need to contact owner to determine status of crossing. Waterward side is buried and not accessible. Landward side headwall is blocked by dense vegetation. Recommend confirming status of flap gate on waterward side and removing dense vegetation form landward side. (O. Magana - DWR UCIP) FIELD_STRUCT_DESC: 36-inch corrugated metal gravity drainage pipe (CMP) through the levee, 16.6 feet below the crown. Flap gate on the waterside (WS) end. [Additional Reference(s): DWR Levee Log, 2002, (HLM 15.93). USACE San Joaquin O&M Manual, Unit No. 601, Part No. 1, 1967, Amended in 1978, Revised 20 June 1985, (HLM 15.91). DWR As-Built Specification No. 59-01, Sheet No. 69, 10 December 1958, (HLM 15.91)]. FS Date: 7/13/2021

LS view: Closeup of slidegate underwater at toe.

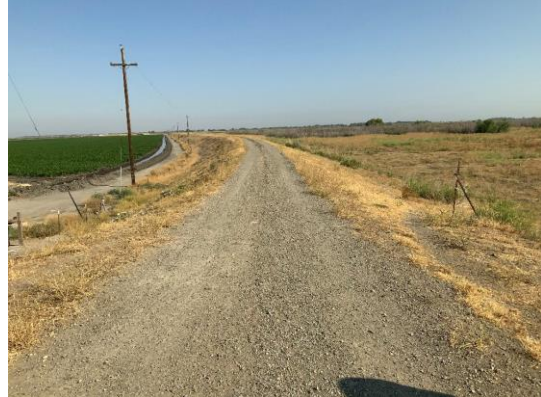
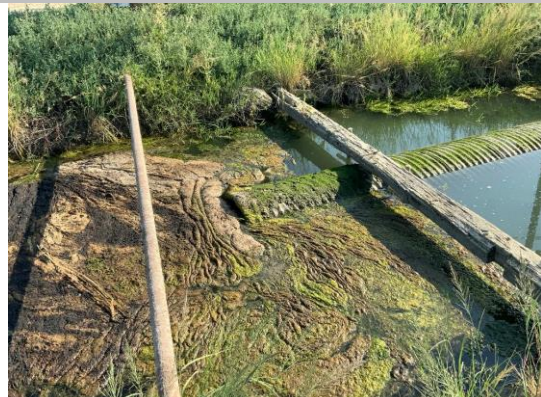
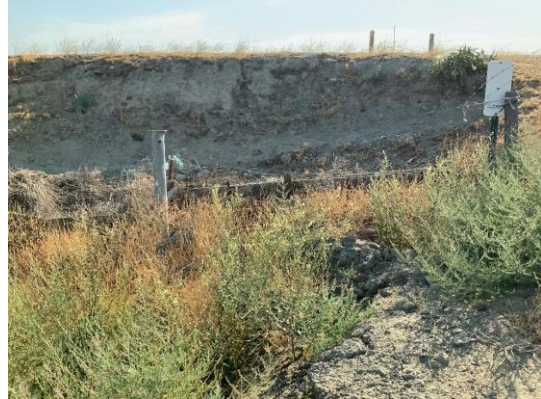
Comment Code						
Inspector Comment						
FS_ID:71135 DS_ID:19559 EP_NO: N/A Repair Type: Non-Urgent Crossing Status: Found UCIP Comments: 07/13/2021 The record remains Non-Urgent. Both WS inlet and LS outlet were underwater at the time of inspection, limited inspection. No permit was found authorizing this encroachment. CVFPB will need to review crossing to determine owner. The UCIP inspection was completed with GEI staff, P. Espinoza. (H. Dunn ? GEI) 04/17/2014 Need to contact owner to determine status of crossing. Unable to confirm pipe diameter. (O. Magana - DWR UCIP) FIELD_STRUCT_DESC: 36-inch corrugated metal pipe (CMP) irrigation siphon through the levee, 5.9 feet below the crown. Slide gate on the waterside (WS). Siphon extends under channel. [Additional Reference(s): USACE San Joaquin O&M Manual, Unit No. 601, Part No. 1, 1967, Amended in 1978, Revised 20 June 1985, (HLM 16.49). DWR As-Built Specification No. 59-01, Sheet No. 69, 10 December 1958, (HLM 16.49)]. FS Date: 7/13/2021

LS view: Close up of pipe outlet underwater off toe.

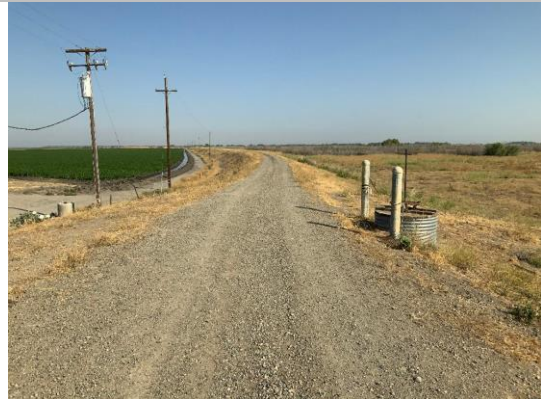
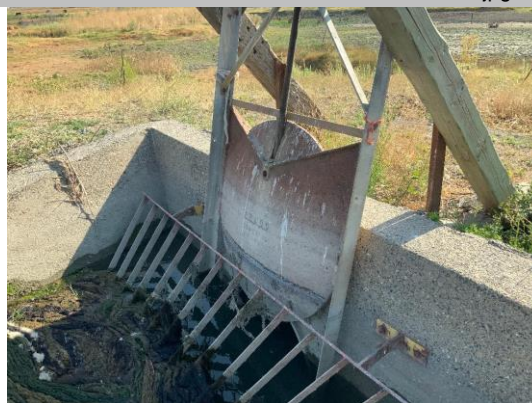
FS_ID:71136
DS_ID:19886
EP_NO: 3040
Repair Type: Non-Urgent
Crossing Status: Indicator Found
UCIP Comments: 07/13/2021 The record is Non-Urgent. WS slidegate is visible off the toe at the end of a small channel with the right diameter size, but does not go through the levee. Confirm with owner on the status of this crossing, alignment, and if this slidegate is the correct indicator. Limited inspection due to water being present around the inlet at time of survey. The UCIP inspection was completed with GEI staff, P. Espinoza. (H. Dunn ? GEI)
FIELD_STRUCT_DESC: 48-inch corrugated metal pipe (CMP) irrigation siphon through the levee, 8.7 feet below the crown. Slide gate on the landside (LS). Cobble revetment around each end of the pipe. Siphon extends under the channel. 24-inch CMP cleanout at the center of the channel with a metal plate cover. (Two reinforced concrete pipe [RCP] siphons across the Eastside Bypass authorized under Permit No. 3040, 1959 - Newhall Land and Farming Company). [Additional Reference(s): DWR Levee Log, 2002, (HLM 16.52)].

WS view: Headwall and slidegate off the toe within small channel.

WS view: Closeup of slidegate off toe.

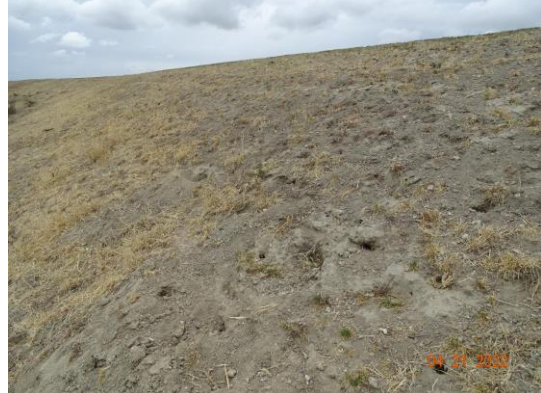
LM Start	17.10	Rating **	M	Issue No.	115
LM End	17.13	Issue Type +	Ma	Location *	LS
Category	Earthen Levee			GPS Latitude/Longitude	
				Start	End
Item	Animal Control			37.141678 °	37.141305 °
				-120.600221 °	-120.599949 °
DWR ID	DWR_NA0010_06_f _ 2021_115				
Comment Code					
A1 : Exterminate rodents and backfill and compact or grout burrows.					
Inspector Comment

Looking along the landside slope at rodent burrows. (Spring 2022)

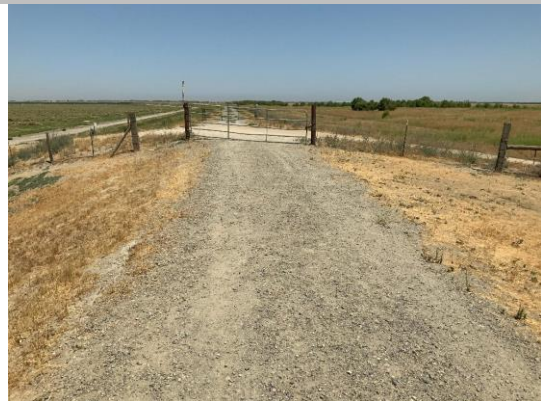
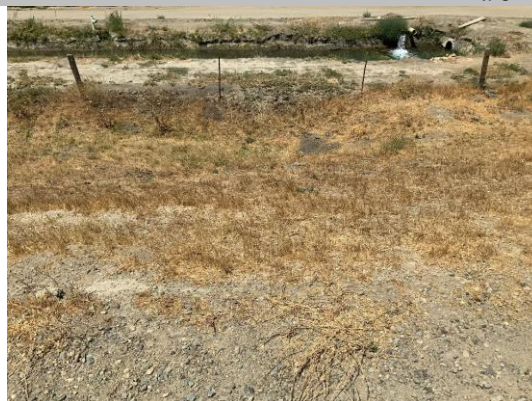
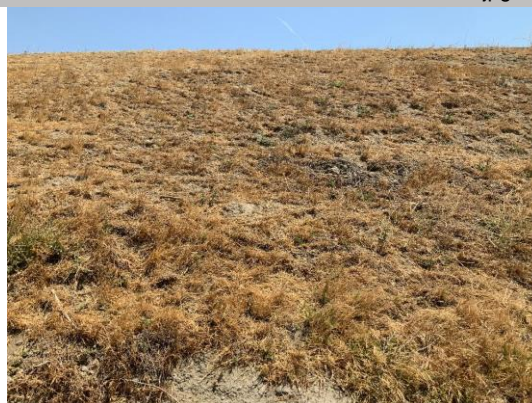
Comment Code						
Inspector Comment						
FS_ID:71137 DS_ID:19887 EP_NO: N/A Repair Type: Non-Urgent Crossing Status: Found UCIP Comments: 07/12/2021 The record remains Non-Urgent. LS pipe inlet filled with sediment, recommend removal. WS flapgate has some vegetation over it, recommend removal. Limited inspection on both WS and LS. No permit was found authorizing this encroachment. CVFPB will need to review crossing to determine owner. The UCIP inspection was completed with GEI staff, P. Espinoza. (H. Dunn ? GEI) 04/17/2014 Sediment build up on landward side toe -- debris blockage. No photos available. Recommend taking photos of crossing. (O. Magana - DWR UCIP) FIELD_STRUCT_DESC: 24-inch corrugated metal gravity drainage pipe (CMP) through the levee, 11.5 feet below the crown. Flap gate on the waterside (WS) end. [Additional Reference(s): DWR Levee Log, 2002, (HLM 18.29). USACE San Joaquin O&M Manual, Unit No. 601, Part No. 1, 1967, Amended in 1978, Revised 20 June 1985, (HLM 18.27). DWR As-Built Specification No. 59-01, Sheet No. 70, 10 December 1958, (HLM 18.27)]. FS Date: 7/13/2021

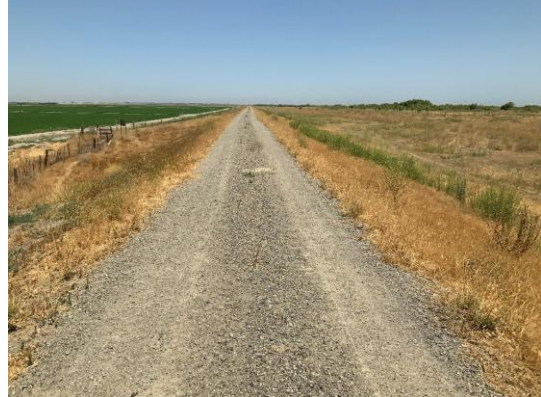
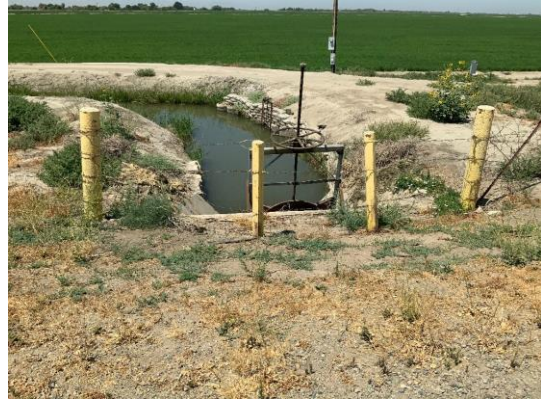
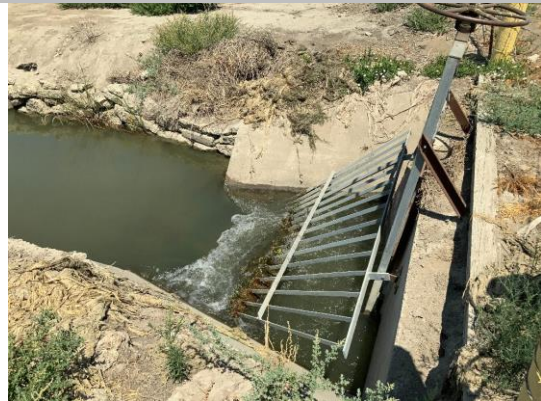
FS_ID:71138
DS_ID:19888
EP_NO: 3040
Repair Type: Non-Urgent
Crossing Status: Found
UCIP Comments: 07/12/2021 The record has been downgraded from Urgent to Non-Urgent. LS gate open and water flowing through during inspection. Did not observe leaks as stated in previous inspection. WS pipe end goes under channel so unable to inspect. The UCIP inspection was completed with GEI staff, P. Espinoza. (H. Dunn ? GEI)

11/01/2018 Signs of pipe leakage (wet spot) visible in floodway. Crossing remains Urgent due to potential leakage along the pipe. Recommend internal inspection to determine pipe integrity through the levee. (O. Magana - DWR UCIP)07/20/2016 Same as previous inspection. Dense vegetation prevents proper inspection along floodway. (O. Magana - DWR UCIP)04/17/2014 Need to contact owner. Leak on waterward toe approximately 15 feet from toe. Good candidate for video or pressure test. (O. Magana - DWR UCIP)
FIELD_STRUCT_DESC: 48-inch corrugated metal pipe (CMP) irrigation siphon through the levee, 8.8 feet below the crown. Slide gate in a pipe riser unit on the landside (LS) slope. Concrete headwall on the LS. Siphon extends under the channel. 24-inch CMP cleanout at the center of the channel with a metal plate cover. (Two reinforced concrete pipe (RCP) siphons across the Eastside Bypass authorized under Permit No. 3040, 1959 - Newhall Land and Farming Company). [Additional Reference(s): DWR Levee Log, 2002, (HLM 18.91). USACE San Joaquin O&M Manual, Unit No. 601, Part No. 1, 1967, Amended in 1978, Revised 20 June 1985, (HLM 18.91). DWR As-Built Specification No. 59-01, Sheet No. 71, 10 December 1958, (HLM 18.91)].

LS view: Slidegate visible at toe from crown.

LS view: Closeup of slidegate at toe.

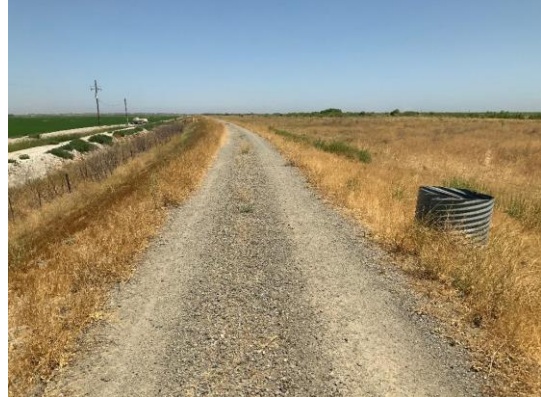
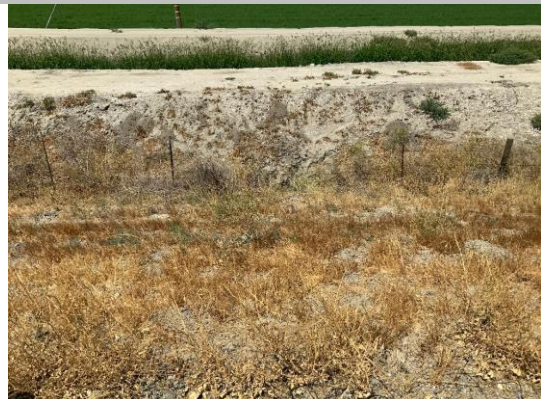
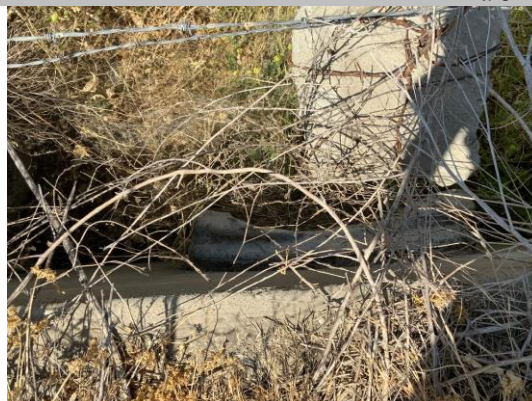
Photo 1 of 3 : UCIP_SP_2022_71139_101558.jpg

Comment Code						
Inspector Comment						
FS_ID:71139 DS_ID:19889 EP_NO: N/A Repair Type: Non-Urgent Crossing Status: Found UCIP Comments: 07/12/2021 The record remains Non-Urgent. Barbed wire over LS end, could not inspect closely. No cover over WS riser, causing safety hazard. Slightly warped edges on both WS and LS pipe inlet/outlet. No permit was found authorizing this encroachment. CVFPB will need to review crossing to determine owner. The UCIP inspection was completed with GEI staff, P. Espinoza. (H. Dunn ? GEI) 04/17/2014 Dense vegetation limits the inspector's visibility to identify signs of pipe failure (leaks) along the landward slope. Recommend removing vegetation along pipe alignment to conduct proper inspection of structure. (O. Magana - DWR UCIP) FIELD_STRUCT_DESC: 24-inch corrugated metal gravity drainage pipe (CMP) through the levee, 10.2 feet below the crown. Slide gate in a pipe riser unit on the waterside (WS) slope. [Additional Reference(s): DWR Levee Log, 2002, (HLM 18.98). USACE San Joaquin O&M Manual, Unit No. 601, Part No. 1, 1967, Amended in 1978, Revised 20 June 1985, (HLM 18.97). DWR As-Built Specification No. 59-01, Sheet No. 71, 10 December 1958, (HLM 18.97)]. FS Date: 7/12/2021

Levee crown.

LS view: Toe from crown.

LS view: Top of pipe inlet at headwall at toe.

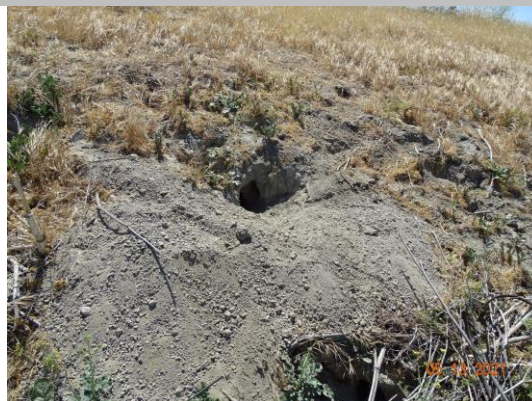
Photo 1 of 1 : SP_2022_NA0010_124_72_20220308_00011.jpg

LM Start	19.07	Rating **	U	Issue No.	72
LM End	19.07	Issue Type +	Ma	Location *	LS
Category	Earthen Levee			GPS Latitude/Longitude	
				Start	End
Item	Animal Control			37.115706 °	37.115706 °
				-120.587036 °	-120.587036 °
DWR ID	DWR_NA0010_06_s_2021_72				
Comment Code					
A1 : Exterminate rodents and backfill and compact or grout burrows.					
Inspector Comment

Large rodent burrows observed in the landside slope. (Spring 2021)

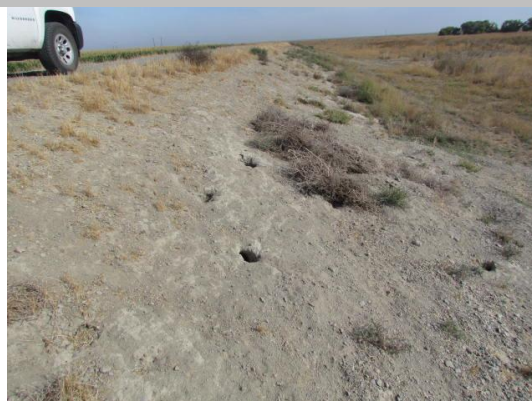
Photo 1 of 1 : SP_2022_NA0010_124_1211_20220308_00053.jpg

LM Start	19.14	Rating **	A/W	Issue No.	1211
LM End	19.14	Issue Type +	Ma	Location *	WS
Category	Earthen Levee			GPS Latitude/Longitude	
				Start	End
Item	Animal Control			37.114793 °	37.114793 °
				-120.587582 °	-120.587582 °
DWR ID	DWR_NA0010_06_s_2022_1211				
Comment Code					
A3 : No rodents visible, but rodent burrows visible; need to backfill and compact or grout burrows.					
Inspector Comment					
Several large rodent holes with more than 2 cubic feet of material were previously noted on the waterside slope.

Looking at several rodent holes on waterward slope. (Fall 2015)

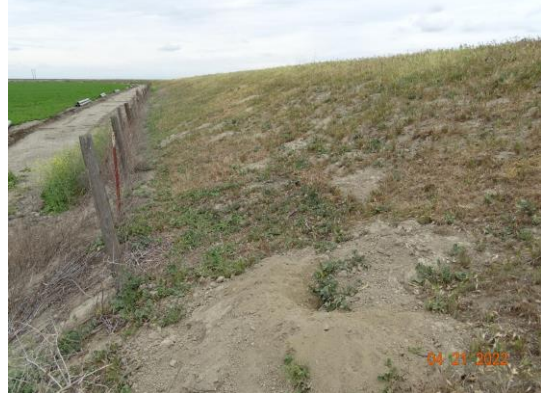
Photo 1 of 1 : SP_2022_NA0010_124_136_20220429_00243.jpg

LM Start	19.22	Rating **	M	Issue No.	136
LM End	19.22	Issue Type +	Ma	Location *	LS
Category	Earthen Levee			GPS Latitude/Longitude	
				Start	End
Item	Animal Control			37.113716 °	37.113716 °
				-120.588225 °	-120.588225 °
DWR ID	DWR_NA0010_06_s_2022_136				
Comment Code					
A3 : No rodents visible, but rodent burrows visible; need to backfill and compact or grout burrows.					
Inspector Comment

Looking downstream along the landside slope at rodent burrows. (Spring 2022)

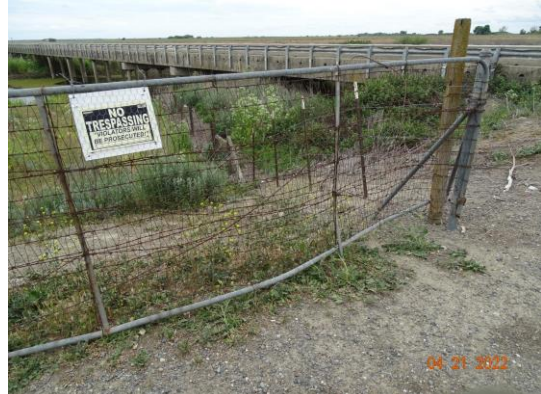
Photo 1 of 1 : SP_2022_NA0010_124_135_20220429_00244.jpg

LM Start	19.23	Rating **	M	Issue No.	135
LM End	19.23	Issue Type +	Ma	Location *	CR
Category	Earthen Levee			GPS Latitude/Longitude	
				Start	End
Item	Access Gates			37.113581 °	37.113581 °
				-120.588310 °	-120.588310 °
DWR ID	DWR_NA0010_06_s_2022_135				
Comment Code					
Inspector Comment					
Bottom of gate has broken off near hinge causing the gate to drag.

View of access gate with a broken bottom hinge. (Spring 2022)
