**Flood Control Project Maintenance
Levee Inspections
LMA District Cover Sheet**

Lower San Joaquin Levee District

**Flood Control Project Maintenance
Levee Inspections
Unit Cover Sheet**

Levee Inspection Report By Mile - Spring 2022

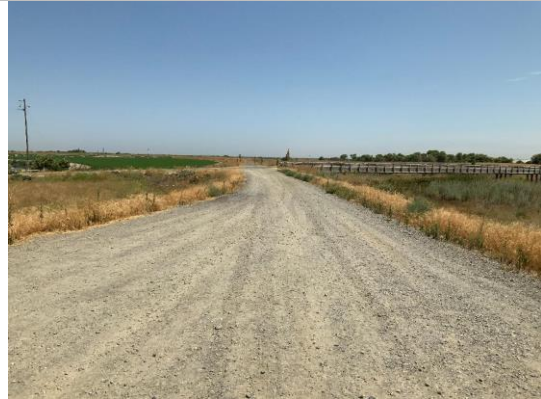
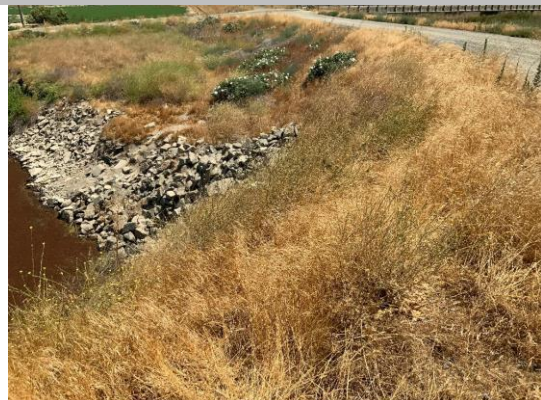
Photo 1 of 3 : UCIP_SP_2022_71140_101574.jpg

Comment Code						
Inspector Comment						
FS_ID:71140 DS_ID:19890 EP_NO: N/A Repair Type: Non-Urgent Crossing Status: Found UCIP Comments: 07/12/2021 The record remains Non-Urgent. WS pipe outlet visible but underwater, unable to inspect closely. LS pipe inlet was not seen, but likely underwater. No permit was found authorizing this encroachment. CVFPB will need to review crossing to determine owner. The UCIP inspection was completed with GEI staff, P. Espinoza. (H. Dunn ? GEI) 04/17/2014 Dense vegetation limits the inspector's visibility to identify signs of pipe failure (leaks) along the slopes. Recommend removing vegetation along pipe alignment to conduct proper inspection of structure. (O. Magana - DWR UCIP) FIELD_STRUCT_DESC: 48-inch corrugated metal gravity drainage pipe (CMP) through the levee, 20.0 feet below the crown. Slide gate in a pipe riser unit on the waterside (WS) slope. Riprap along the landside (LS) slope. [Additional Reference(s): DWR Levee Log, 2002, (HLM 19.36). USACE San Joaquin O&M Manual, Unit No. 601, Part No. 1, 1967, Amended in 1978, Revised 20 June 1985, (HLM 19.36). DWR As-Built Specification No. 59-01, Sheet No. 72, 10 December 1958, (HLM 19.36)]. FS Date: 7/12/2021

Levee crown.

LS view: Slope from crown, no pipe visible.

WS view: Slidegate visible on slope from crown.

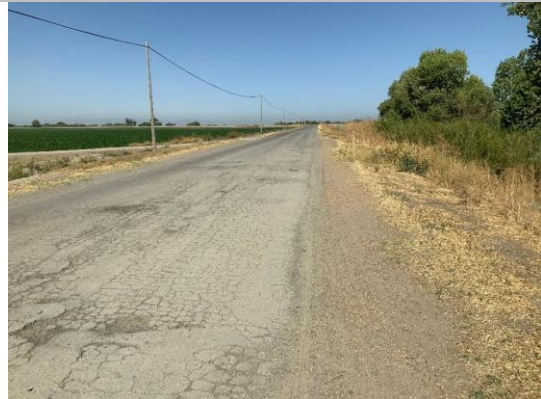
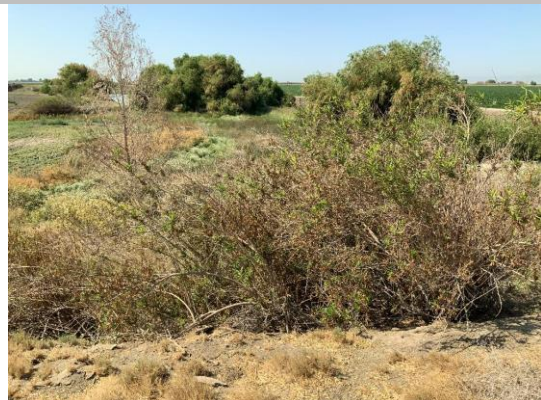
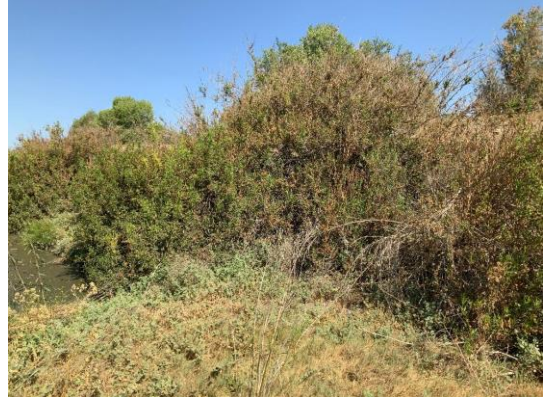
Photo 1 of 3 : UCIP_SP_2022_71141_101582.jpg

Comment Code						
Inspector Comment						
FS_ID:71141 DS_ID:19891 EP_NO: N/A Repair Type: Non-Urgent Crossing Status: Found UCIP Comments: 07/12/2021 The record remains Non-Urgent. Limited inspection due to dense vegetation on LS and WS ends, LS headwall just barely visible, recommend removal of vegetation. No permit was found authorizing this encroachment. CVFPB will need to review crossing to determine owner. The UCIP inspection was completed with GEI staff, P. Espinoza. (H. Dunn ? GEI) 04/17/2014 Dense vegetation limits the inspector's visibility to identify signs of pipe failure (leaks) along the slopes. Recommend removing vegetation along pipe alignment to conduct proper inspection of structure. (O. Magana - DWR UCIP) FIELD_STRUCT_DESC: 30-inch by 30-inch reinforced concrete box gravity drainage culvert (RCBC) through the levee, 14.0 feet below the crown. Flap gate on the waterside (WS) end. [Additional Reference(s): DWR Levee Log, 2002, (HLM 19.82). USACE San Joaquin O&M Manual, Unit No. 601, Part No. 1, 1967, Amended in 1978, Revised 20 June 1985, (HLM 19.85). DWR As-Built Specification No. 59-01, Sheet No. 73, 10 December 1958, (HLM 19.85)]. FS Date: 7/12/2021

Levee crown.

LS view: Toe from crown.

LS view: Dense vegetation over pipe inlet at toe, pipe not visible.

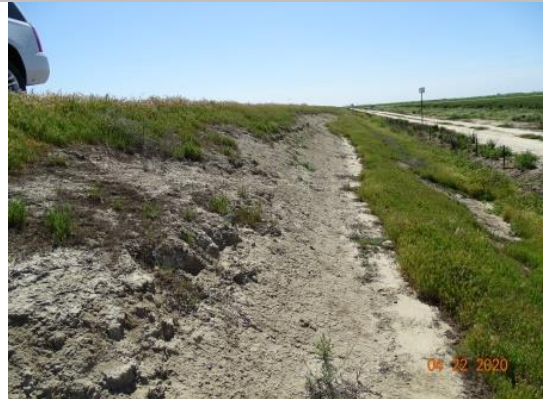
Photo 1 of 1 : SP_2022_NA0010_124_1209_20220308_00052.jpg

LM Start	20.79	Rating **	M	Issue No.	1209
LM End	21.19	Issue Type +	Ma	Location *	LS
Category	Earthen Levee			GPS Latitude/Longitude	
				Start	End
Item	Erosion / Livestock			37.113107 °	37.108653 °
				-120.563782 °	-120.558977 °
DWR ID	DWR_NA0010_06_s_2015_1209				
Comment Code					
E4 : Repair the levee slope damaged by livestock and prevent large animal access.					
Inspector Comment					
Erosion on landside slope greater than 3 inches. Erosion caused by livestock.

Erosion on the landside slope from livestock activity. (Spring 2020)

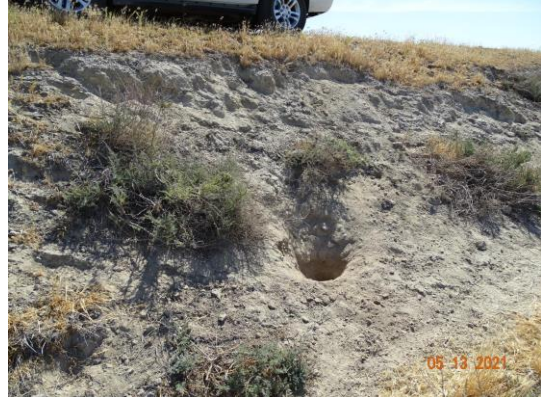
Photo 1 of 1 : SP_2022_NA0010_124_70_20220308_00010.jpg

LM Start	22.15	Rating **	U	Issue No.	70
LM End	22.15	Issue Type +	Ma	Location *	LS
Category	Earthen Levee			GPS Latitude/Longitude	
				Start	End
Item	Animal Control			37.097885 °	37.097885 °
				-120.548108 °	-120.548108 °
DWR ID	DWR_NA0010_06_s_2021_70				
Comment Code					
A3 : No rodents visible, but rodent burrows visible; need to backfill and compact or grout burrows.					
Inspector Comment

View of large rodent burrows in the landside slope. (Spring 2021)

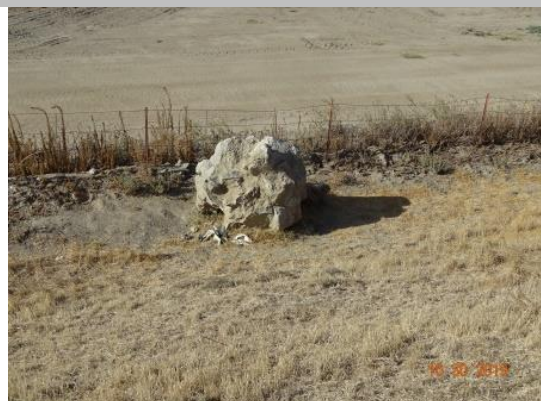
Photo 1 of 1 : SP_2022_NA0010_124_117_20220308_00040.jpg

LM Start	22.87	Rating **	M	Issue No.	117
LM End	22.87	Issue Type +	Ma	Location *	LS
Category	Earthen Levee			GPS Latitude/Longitude	
				Start	End
Item	Encroachments			37.089954 °	37.089954 °
				-120.539535 °	-120.539535 °
DWR ID	DWR_NA0010_06_f_2019_117				
Comment Code					
DE : Debris					
Inspector Comment					
Large block of concrete left on the landside toe.

Large concrete block left on the landside toe. (Fall 2019)

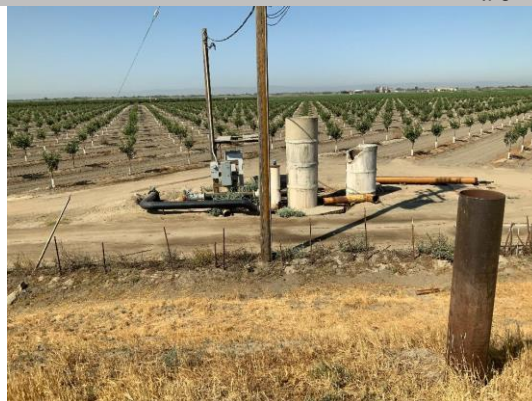
Photo 3 of 3 : UCIP_SP_2022_71142_101597.jpg

LM Start	22.92	Rating **	M	Issue No.	58 (cont)
LM End	22.92	Issue Type +	En	Location *	
Category	Supplemental			GPS Latitude/Longitude	
				Start	End
Item	DWR UCIP Field Study			37.089411 °	37.089411 °
				-120.538940 °	-120.538940 °
DWR ID	19812

LS view: Risers and pumps off the toe from crown.

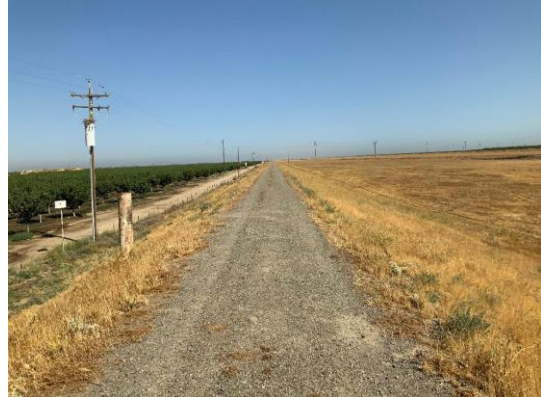
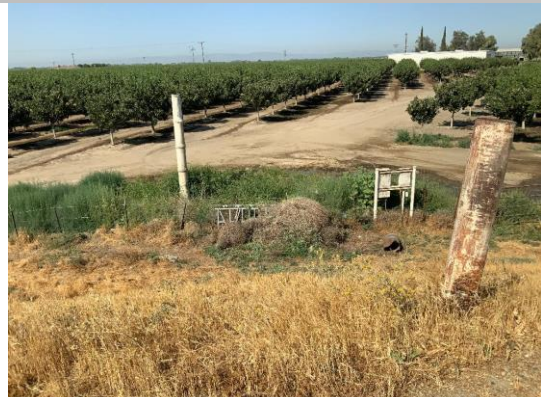
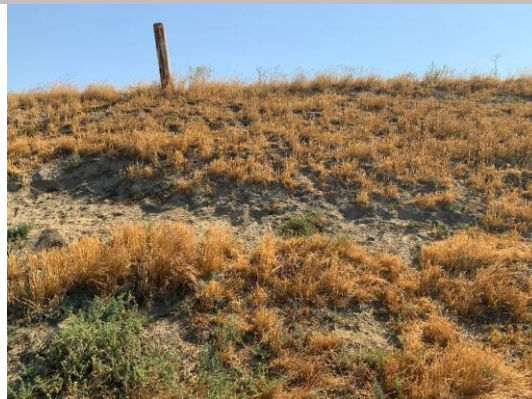
Photo 1 of 3 : UCIP_SP_2022_71143_101614.jpg

Comment Code						
Inspector Comment						
FS_ID:71143 DS_ID:19879 EP_NO: 13638 Repair Type: Non-Urgent Crossing Status: Found UCIP Comments: 07/12/2021 The record remains Non-Urgent. WS pump removed and wires cut. Large pieces of pipe appear to be out of place, crossing appears abandoned. Pump off LS toe behind fence is running for well water. Recommend contacting owner to confirm status of crossing. Erosion and instability underneath concrete pad meant for pump on the edge of the WS outlet channel. The UCIP inspection was completed with GEI staff, P. Espinoza. (H. Dunn ? GEI) 04/17/2014 Need to contact owner to determine status. Crossing has been modified. (O. Magana - DWR UCIP) FIELD_STRUCT_DESC: 16-inch coated steel irrigation discharge pipe through the levee, 3.5 feet below the crown. Cutoff wall around the pipe at the center of the levee. Pump on the waterside (WS). Siphon breaker on the landside (LS) shoulder. Intake trench on the WS. (Pump and 16-inch pipe authorized under Permit No. 13638, 1983 - Hamonds Ranch). [Additional Reference(s): DWR Levee Log, 2002, (HLM 23.92)]. FS Date: 7/12/2021

Levee crown.

LS view: Toe from crown.

LS view: Siphon breaker visible on crown and slope from toe.

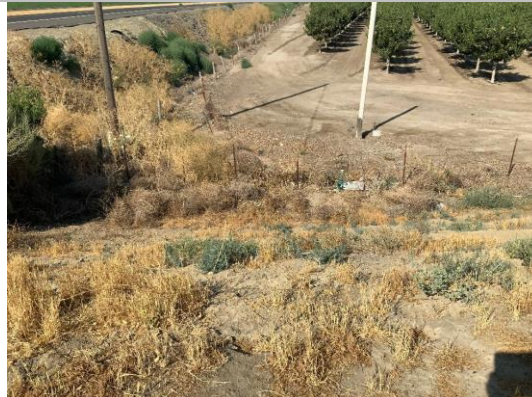
Photo 2 of 3 : UCIP_SP_2022_71144_101620.jpg

LS view: Toe from crown, no pipe visible.

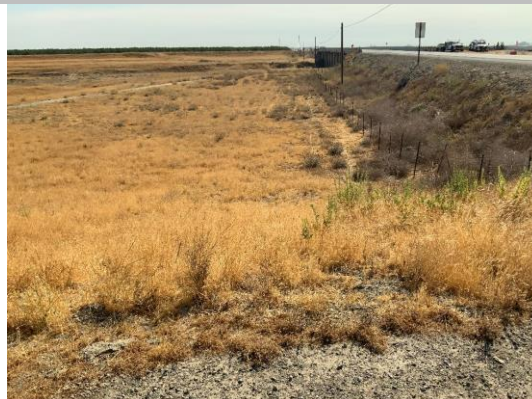
Photo 3 of 3 : UCIP_SP_2022_71144_101621.jpg

WS view: Toe from crown, no pipe visible.

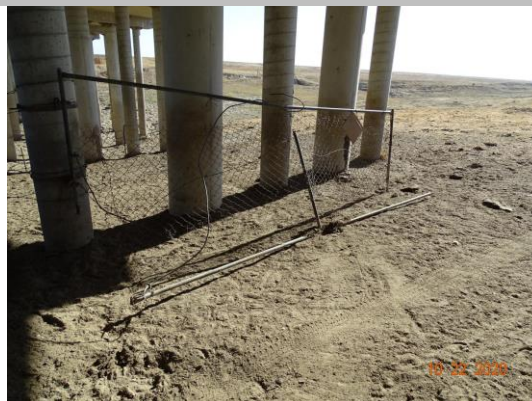
Photo 1 of 1 : SP_2022_NA0010_124_78_20220308_00014.jpg

LM Start	24.46	Rating **	M	Issue No.	78
LM End	24.46	Issue Type +	Ma	Location *	WS
Category	Earthen Levee			GPS Latitude/Longitude	
				Start	End
Item	Access Gates			37.072606 °	37.072606 °
				-120.520748 °	-120.520748 °
DWR ID	DWR_NA0010_06_f_2020_78				
Comment Code					
Inspector Comment					
Under eastbound 152. Gate in channel under highway 152 should be repaired.

View of damaged access gate under highway 152. (Fall 2020)

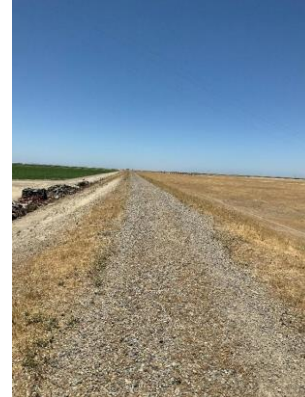
Photo 1 of 3 : UCIP_SP_2022_71145_103927.jpg

Comment Code					
Inspector Comment					
FS_ID:71145 DS_ID:19568 EP_NO: 13178 Repair Type: Non-Urgent Crossing Status: Not Found UCIP Comments: 06/24/2021 The record is Non-Urgent. Pipe not found by visual inspection. Confirm with owner on the status of this pipe. The UCIP inspection was completed with GEI staff, H.Dunn. (P.Espinoza ? GEI) FIELD_STRUCT_DESC: 16-inch coated steel drainage discharge pipe through the levee, 2.0 feet below the crown. Metal cutoff wall around the pipe at the center of the levee. Siphon breaker on the apex of the pipe on the landside (LS) shoulder. Turbine pump on a concrete foundation. Holding basin on the waterside (WS). Electrical conduit through the levee. Service pole on the LS. Riprap on the WS slope. Inlet channel from main river to WS toe. (Turbine pump and 16-inch discharge pipe authorized under Permit No. 13178, 1981 - Menefee Hill Ranch Company). FS Date: 6/24/2021 12:48:00 PM

View from levee crown.

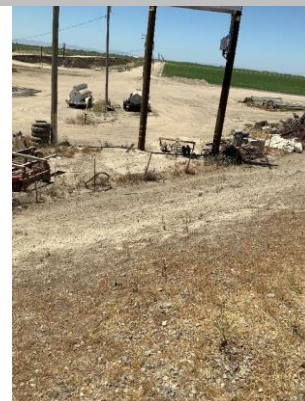
Photo 2 of 3 : UCIP_SP_2022_71145_103928.jpg

LS view: Toe from crown, no pipe visible.

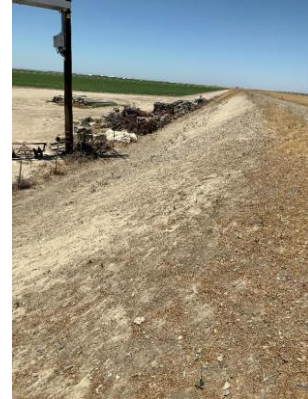
Photo 3 of 3 : UCIP_SP_2022_71145_103929.jpg

LS view: Slope from crown.

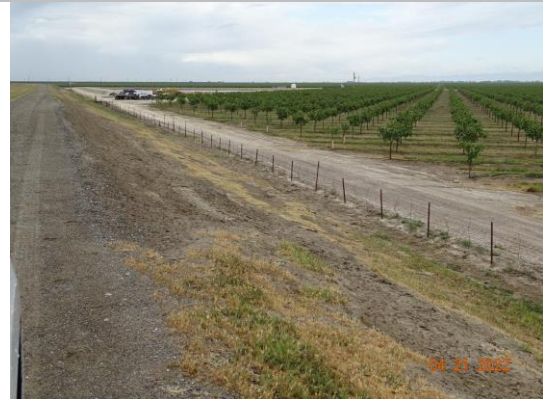
Photo 1 of 1 : SP_2022_NA0010_124_3_20220429_00245.jpg

LM Start	27.43	Rating **	U	Issue No.	3
LM End	27.99	Issue Type +	Ma	Location *	LS
Category	Earthen Levee			GPS Latitude/Longitude	
				Start	End
Item	Erosion / Livestock			37.036955 °	37.032762 °
				-120.484395 °	-120.481078 °
DWR ID	DWR_NA0010_06_s_2012_3				
Comment Code					
E4 : Repair the levee slope damaged by livestock and prevent large animal access.					
Inspector Comment					
Landside erosion and slope instability caused by livestock. Erosion greater than 3" in depth on landside slope. Levee crown has narrowed within this reach.

Looking south along landside slope. (Spring 2022)

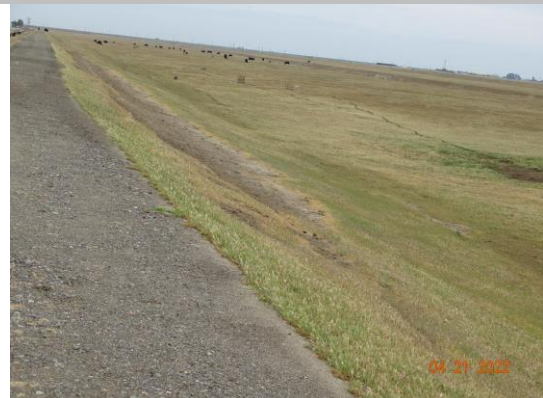
Photo 1 of 1 : SP_2022_NA0010_124_132_20220429_00246.jpg

LM Start	27.65	Rating **	M	Issue No.	132
LM End	27.93	Issue Type +	Ma	Location *	WS
Category	Earthen Levee			GPS Latitude/Longitude	
				Start	End
Item	Erosion / Livestock			37.036856 °	37.033468 °
				-120.484309 °	-120.481709 °
DWR ID	DWR_NA0010_06_s_2022_132				
Comment Code					
E4 : Repair the levee slope damaged by livestock and prevent large animal access.					
Inspector Comment

View of erosion on the waterside slope. (Spring 2022)

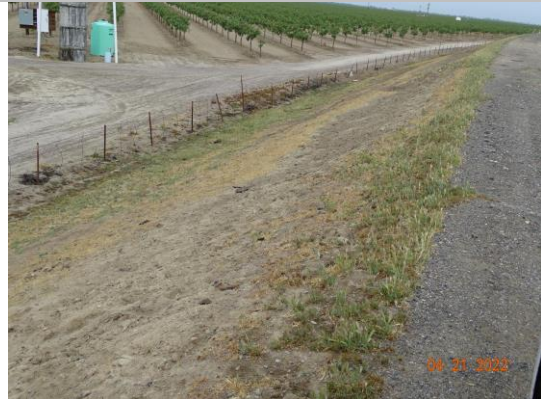
Photo 1 of 1 : SP_2022_NA0010_124_131_20220429_00247.jpg

LM Start	28.18	Rating **	A/W	Issue No.	131
LM End	28.18	Issue Type +	Ma	Location *	LS
Category	Earthen Levee			GPS Latitude/Longitude	
				Start	End
Item	Erosion / Livestock			37.030925 °	37.030925 °
				-120.478368 °	-120.478368 °
DWR ID	DWR_NA0010_06_s_2022_131				
Comment Code					
E4 : Repair the levee slope damaged by livestock and prevent large animal access.					
Inspector Comment

View of damage to the landside slope. (Spring 2022)

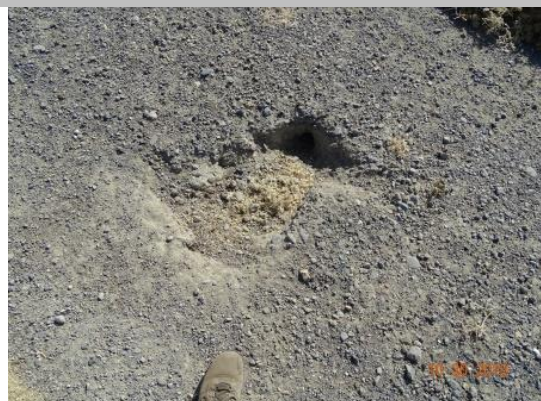
Photo 1 of 1 : SP_2022_NA0010_124_19_20220308_00004.jpg

LM Start	28.47	Rating **	M	Issue No.	19
LM End	28.53	Issue Type +	Ma	Location *	LS
Category	Earthen Levee			GPS Latitude/Longitude	
				Start	End
Item	Animal Control			37.029937 °	37.029977 °
				-120.473384 °	-120.472266 °
DWR ID	DWR_NA0010_06_s_2015_19				
Comment Code					
A3 : No rodents visible, but rodent burrows visible; need to backfill and compact or grout burrows.					
Inspector Comment					
Rodent burrows are also on the crown.

View of rodent burrow in the levee crown. (Fall 2019)

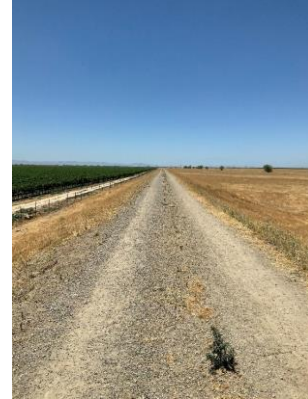
Photo 1 of 3 : UCIP_SP_2022_71146_103933.jpg

Comment Code						
Inspector Comment						
FS_ID:71146 DS_ID:19881 EP_NO: N/A Repair Type: Non-Urgent Crossing Status: Found UCIP Comments: 06/24/2021 The record remains Non-Urgent. WS inlet had sediment build up in pipe; recommend removal. Build up of debris on WS riser on WS slope; recommend removal. WS CMP riser is missing lid, causing safety hazard. LS pipe outlet had elevated water levels around the headwall and pipe, limited ability to inspect closely. Unidentified pipe has been installed off 15 feet from the toe of LS headwall; does not affect crossing. No permit was found authorizing this encroachment. CVFPB will need to review crossing to determine owner. The UCIP inspection was completed with GEI staff, H.Dunn. (P.Espinoza ? GEI) 04/10/2014 Dense vegetation limits the inspector's visibility to identify signs of pipe failure (leaks) along the slopes. Recommend removing vegetation along pipe alignment to conduct proper inspection of structure. (O. Magana - DWR UCIP) FIELD_STRUCT_DESC: 36-inch corrugated metal gravity irrigation pipe (CMP) through the levee, 12.4 feet below the crown. Slide gate in a 48-inch CMP riser unit on the waterside (WS) slope. Concrete U-shaped headwall on each end. Cobble pad on the landside (LS). [Additional Reference(s): DWR Levee Log, 2002, (HLM 29.34). USACE San Joaquin O&M Manual, Unit No. 601, Part No. 1, 1967, Amended in 1978, Revised 20 June 1985, (HLM 29.34). DWR As-Built Specification No. 64-01, Sheet No. 10, 6 November 1963, (HLM 29.34)]. FS Date: 6/24/2021 4:24:00 PM

View from levee crown.

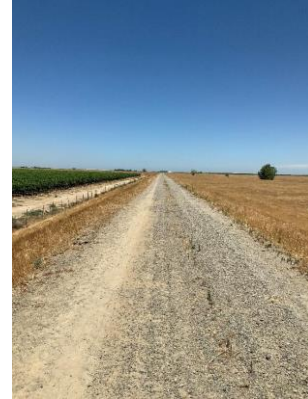
Photo 1 of 3 : UCIP_SP_2022_71147_103940.jpg

Comment Code					
Inspector Comment					
FS_ID:71147 DS_ID:19882 EP_NO: N/A Repair Type: Non-Urgent Crossing Status: Found UCIP Comments: 06/24/2021 The record remains Non-Urgent. Altered crossing -- Two 12" plastic pipes going through LS outlet, recommend removing before flood season. No permit was found authorizing this encroachment. CVFPB will need to review crossing to determine owner. The UCIP inspection was completed with GEI staff, H.Dunn. (P.Espinoza ? GEI) 04/10/2014 Altered crossing--steel pipe section on landward side and concrete pipe section on waterward side. Joints on waterward side separated. Need to contact owner to determine status. (O. Magana - DWR UCIP) FIELD_STRUCT_DESC: [Rodunder Siphon] 48-inch reinforced concrete pipe (RCP) irrigation siphon through the levee, 14.5 feet below the crown. Concrete U-shaped headwall on the outlet structure on the landside (LS) end. Slide gate mounted on the headwall. [Additional Reference(s): DWR Levee Log, 2002, (HLM 30.26). USACE San Joaquin O&M Manual, Unit No. 601, Part No. 1, 1967, Amended in 1978, Revised 20 June 1985, (HLM 30.27). DWR As-Built Specification No. 64-01, Sheet No. 11, 6 November 1963, (HLM 30.27)]. FS Date: 6/24/2021 10:15:00 AM

View of levee crown.

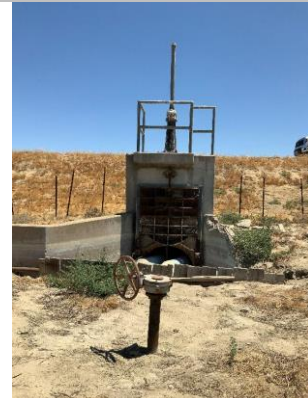
Photo 2 of 3 : UCIP_SP_2022_71147_103941.jpg

LS view: Concrete headwall, slidegate, and slope at toe.

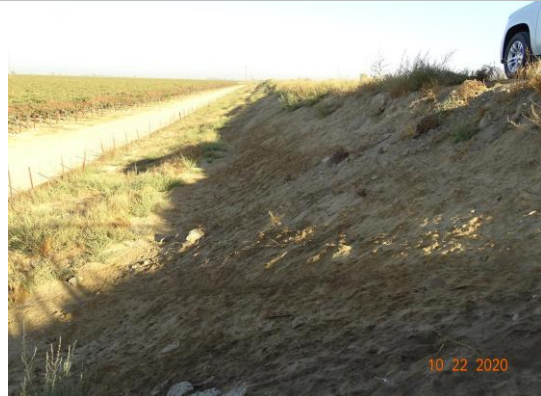
Photo 1 of 1 : SP_2022_NA0010_124_1207_20220308_00050.jpg

LM Start	30.81	Rating **	M	Issue No.	1207
LM End	31.06	Issue Type +	Ma	Location *	LS
Category	Earthen Levee			GPS Latitude/Longitude	
				Start	End
Item	Erosion / Livestock			37.021615 °	37.018428 °
				-120.437587 °	-120.435378 °
DWR ID	DWR_NA0010_06_s_2015_1207				
Comment Code					
E4 : Repair the levee slope damaged by livestock and prevent large animal access.					
Inspector Comment					
Landside erosion greater than 1" in depth and greater than 3" in length. Erosion is caused by livestock traffic.

Looking upstream at livestock damage to the landside slope. (Fall 2020)

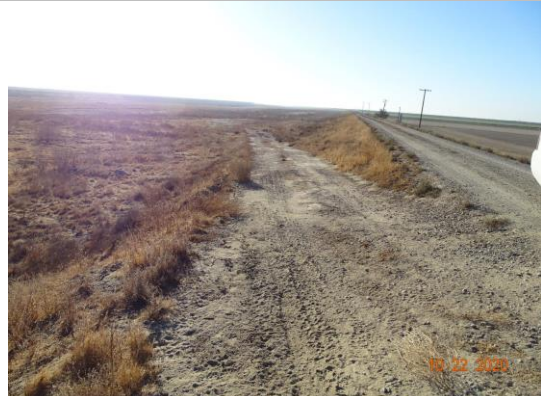
Photo 1 of 1 : SP_2022_NA0010_124_80_20220308_00016.jpg

LM Start	31.10	Rating **	U	Issue No.	80
LM End	31.10	Issue Type +	En	Location *	WS
Category	Earthen Levee			GPS Latitude/Longitude	
				Start	End
Item	Encroachments			37.017907 °	37.017907 °
				-120.434970 °	-120.434970 °
DWR ID	DWR_NA0010_06_s_2017_80				
Comment Code					
RA : Ramp					
Inspector Comment					
Farmer installed ramp on waterside slope.

Looking upstream at ramp on the waterside slope. (Fall 2020)

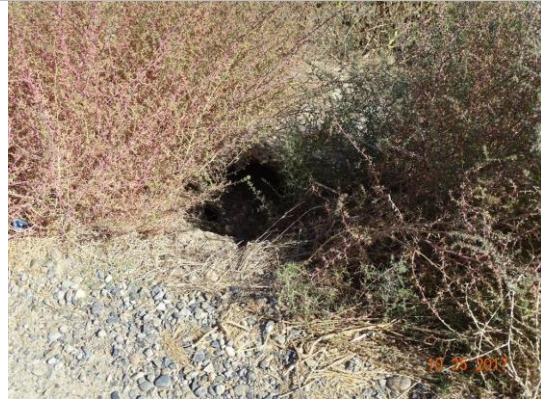
Photo 1 of 1 : SP_2022_NA0010_124_82_20220308_00018.jpg

LM Start	31.14	Rating **	A/W	Issue No.	82
LM End	31.14	Issue Type +	Ma	Location *	WS
Category	Earthen Levee			GPS Latitude/Longitude	
				Start	End
Item	Animal Control			37.017445 °	37.017445 °
				-120.434713 °	-120.434713 °
DWR ID	DWR_NA0010_06_f _ 2017_82				
Comment Code					
A3 : No rodents visible, but rodent burrows visible; need to backfill and compact or grout burrows.					
Inspector Comment

Looking east at the waterside slope.

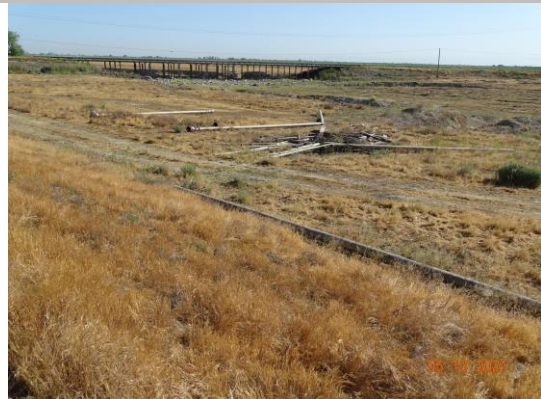
Photo 1 of 1 : SP_2022_NA0010_124_128_20220308_00048.jpg

LM Start	31.18	Rating **	M	Issue No.	128
LM End	31.18	Issue Type +	En	Location *	WS
Category	Earthen Levee			GPS Latitude/Longitude	
				Start	End
Item	Encroachments			37.016932 °	37.016932 °
				-120.434346 °	-120.434346 °
DWR ID	DWR_NA0010_06_s_2019_128				
Comment Code					
PI : Pipe					
Inspector Comment					
Temporary pipe was removed from crown crossing and has been discarded in the channel.

Disassembled pipe crossing left in the channel. (Spring 2021)

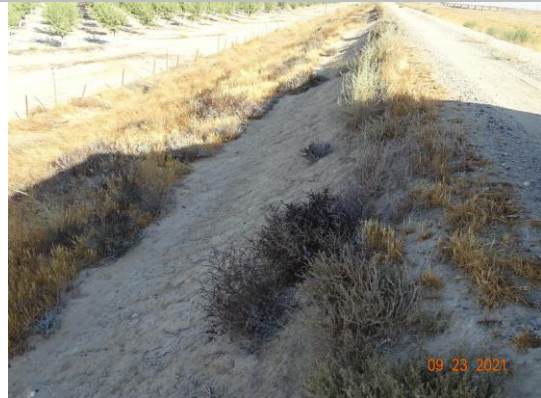
Photo 1 of 1 : SP_2022_NA0010_124_108_20220308_00036.jpg

LM Start	31.50	Rating **	M	Issue No.	108
LM End	31.70	Issue Type +	Ma	Location *	LS
Category	Earthen Levee			GPS Latitude/Longitude	
				Start	End
Item	Erosion / Livestock			37.012830 °	37.010335 °
				-120.431523 °	-120.429817 °
DWR ID	DWR_NA0010_06_f_2021_108				
Comment Code					
E4 : Repair the levee slope damaged by livestock and prevent large animal access.					
Inspector Comment

View of the landside slope looking downstream. (Fall 2021)

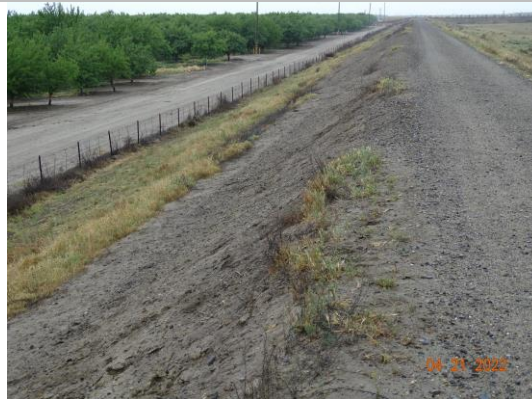
Photo 1 of 1 : SP_2022_NA0010_124_129_20220429_00248.jpg

LM Start	32.37	Rating **	U	Issue No.	129
LM End	32.88	Issue Type +	Ma	Location *	LS
Category	Earthen Levee			GPS Latitude/Longitude	
				Start	End
Item	Erosion / Livestock			37.003251 °	36.997745 °
				-120.421556 °	-120.415197 °
DWR ID	DWR_NA0010_06_s_2022_129				
Comment Code					
E4 : Repair the levee slope damaged by livestock and prevent large animal access.					
Inspector Comment					
Slope damage from livestock. Damage is beginning to erode into levee crown.

Erosion from animal activity along the landside slope. (Spring 2022)

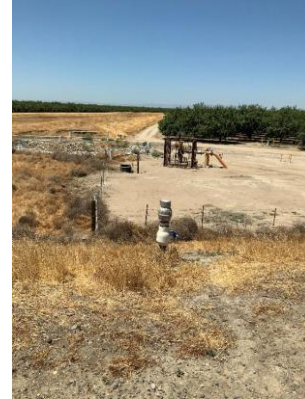
Photo 1 of 3 : UCIP_SP_2022_71148_103947.jpg

Comment Code						
Inspector Comment						
FS_ID:71148 DS_ID:19883 EP_NO: 6416-C Repair Type: Non-Urgent Crossing Status: Found UCIP Comments: 06/24/2021 The record remains Non-Urgent. Limited inspection of LS due to barbed wire and accessibility issues. The UCIP inspection was completed with GEI staff, H.Dunn. (P.Espinoza ? GEI) 04/10/2014 Crossing updated--need to contact owner to determine permit issued by CVFPB for authorized changes. (O. Magana - DWR UCIP) FIELD_STRUCT_DESC: 20-inch coated steel drainage discharge pipe through the levee, 3.9 feet below the crown. Cutoff wall around the pipe at the center of the levee. Slant pump on the waterside (WS) slope. Siphon breaker on the apex of the pipe on the landside (LS) shoulder. Capped with a welded plate on the LS end. Electrical conduit through the levee. (Slant pump and 18-inch steel pipe authorized under Permit No. 6416-A, 1975 - Triangle "T" Ranch, Inc.). [Additional Reference(s): DWR Levee Log, 2002, (HLM 32.97), 18-inch pipe listed]. FS Date: 6/24/2021 12:23:00 PM

LS view: Siphon breaker located on slope. Additional structures visible off the toe.

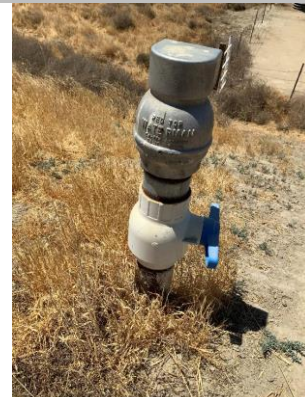
Photo 2 of 3 : UCIP_SP_2022_71148_103948.jpg

LS view: Closeup of siphon breaker on the apex of the pipe on shoulder.

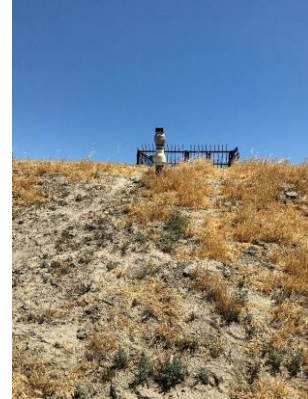
Photo 3 of 3 : UCIP_SP_2022_71148_103949.jpg

LS view: Slope from toe.

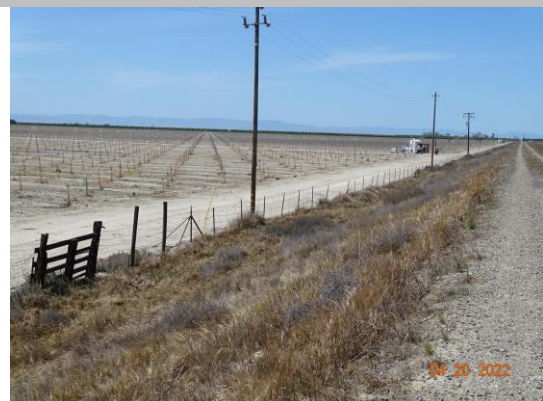
Photo 1 of 1 : SP_2022_NA0010_124_96_20220429_00249.jpg

LM Start	34.62	Rating **	M	Issue No.	96
LM End	36.47	Issue Type +	Ma	Location *	LS
Category	Earthen Levee			GPS Latitude/Longitude	
				Start	End
Item	Vegetation			36.978955 °	36.974155 °
				-120.394385 °	-120.363314 °
DWR ID	DWR_NA0010_06_s_2022_96				
Comment Code					
V1 : Control annual grass and weeds on the levee slopes and easements.					
Inspector Comment

View of the landside slope looking downstream. (Spring 2022)

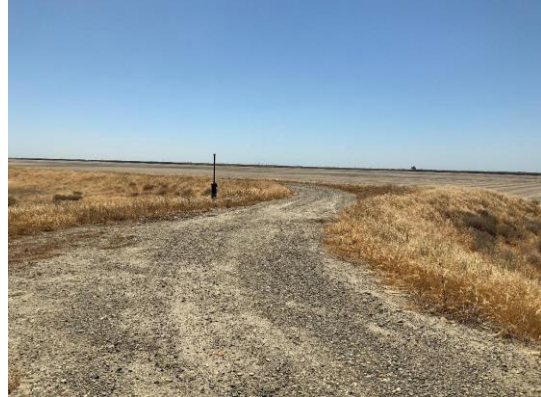
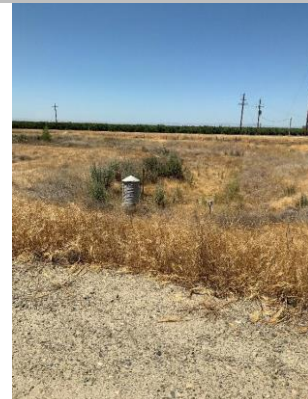
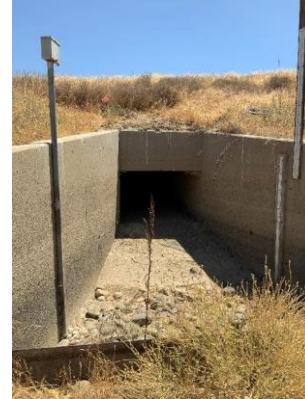
Comment Code						
Inspector Comment						
FS_ID:71149 DS_ID:19813 EP_NO: N/A Repair Type: Non-Urgent Crossing Status: Found UCIP Comments: 06/24/2021 The record remains Non-Urgent. No permit was found authorizing this encroachment. Crossing appears in good condition. CVFPB will need to review crossing to determine owner. The UCIP inspection was completed with GEI staff, H.Dunn. (P.Espinoza ? GEI) 04/10/2014 Dense vegetation limits the inspector's visibility to identify signs of pipe failure (leaks) along the slope. Recommend removing vegetation along pipe alignment to conduct proper inspection of structure and appurtenances. High vegetation along crossing alignment--recommend removing vegetation along pipe crossing. (O. Magana - DWR UCIP) FIELD_STRUCT_DESC: [Fresno River Irrigation Structure] 72-inch by 48-inch reinforced concrete box gravity irrigation culvert (RCBC) through the levee, 15.1 feet below the crown. Slide gate in a concrete riser unit on the waterside (WS) slope. Concrete U-shaped headwall on each end. Landside (LS) channel cobble revetted for 8 feet. [Additional Reference(s): DWR Levee Log, 2002, (HLM 35.33). USACE San Joaquin O&M Manual, Unit No. 601, Part No. 1, 1967, Amended in 1978, Revised 20 June 1985, (HLM 35.33). DWR As-Built Specification No. 64-42, Sheet No. 9, 13 August 1964, (HLM 35.33)]. FS Date: 6/24/2021 12:47:00 PM

View of levee crown.

LS view of slope to toe.

LS view: concrete headwall and inlet.

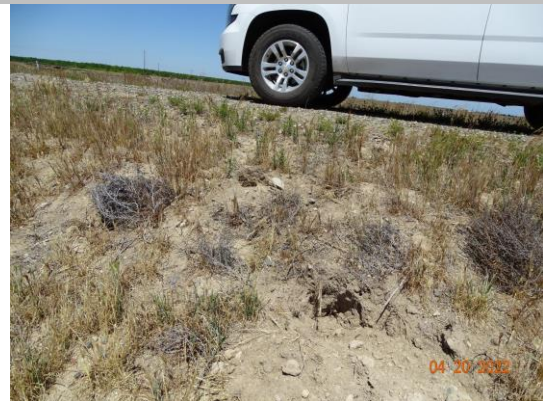
Photo 1 of 1 : SP_2022_NA0010_124_130_20220429_00250.jpg

LM Start	35.51	Rating **	M	Issue No.	130
LM End	35.51	Issue Type +	Ma	Location *	LS
Category	Earthen Levee			GPS Latitude/Longitude	
				Start	End
Item	Animal Control			36.974349 °	36.974349 °
				-120.380584 °	-120.380584 °
DWR ID	DWR_NA0010_06_s_2022_130				
Comment Code					
A3 : No rodents visible, but rodent burrows visible; need to backfill and compact or grout burrows.					
Inspector Comment

Representative view of rodent burrows in the landside slope. (Spring 2022)

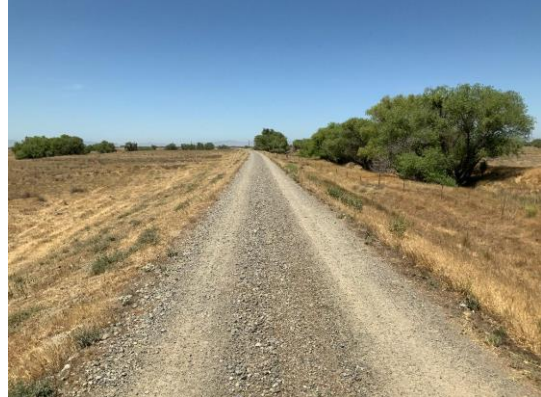
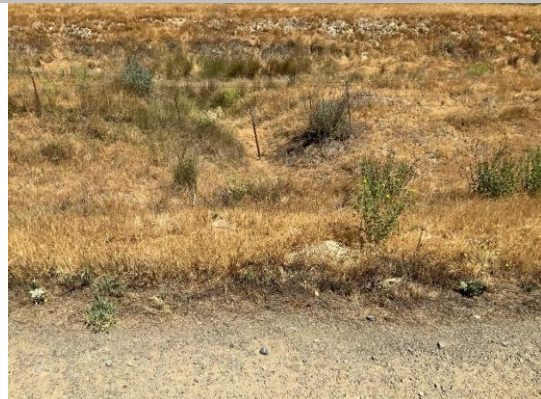
Comment Code						
Inspector Comment						
FS_ID:71165 DS_ID:19892 EP_NO: N/A Repair Type: Non-Urgent Crossing Status: Found UCIP Comments: 06/2/2021 Record remains Non-Urgent. DWR DMP internal inspection has not found pipe integrity issues. LOF of crossing is less or equal to 4.0. Recommend next video inspection in 5 years. No permit was found authorizing this encroachment. CVFPB will need to review crossing to determine owner. The UCIP inspection was completed with GEI staff, P. Espinoza. (H. Dunn ? GEI) 07/20/2016 Inlet blocked off by wooden board. Dense vegetation limits the inspector's visibility to identify signs of pipe failure (leaks) along WS and LS. Crossing downgraded from Urgent to Non-Urgent. (O. Magana - DWR UCIP)04/15/2014 Flapgate partially blocked by soil buildup at WS toe. (W. Wylie - DWR UCIP) FIELD_STRUCT_DESC: 24-inch corrugated metal gravity drainage pipe (CMP) through the levee, 10.8 feet below the crown. Flap gate on the waterside (WS) end. Concrete headwall on the landside (LS) end. Concrete U-shaped headwall on the WS end. [Additional Reference(s): DWR Levee Log, 2002, (HLM 0.08). USACE San Joaquin O&M Manual, Unit No. 601, Part No. 1, 1967, Amended in 1978, Revised 20 June 1985, (HLM 0.07). DWR As-Built Specification No. 63-25, Sheet No. 11, 9 May 1963, (HLM 0.07)]. FS Date: 6/2/2021

Levee crown looking downstream.

LS view: Toe from crown.

LS view: Slope and headwall at toe.

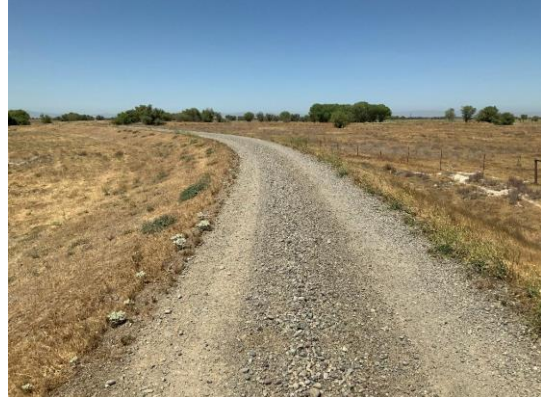
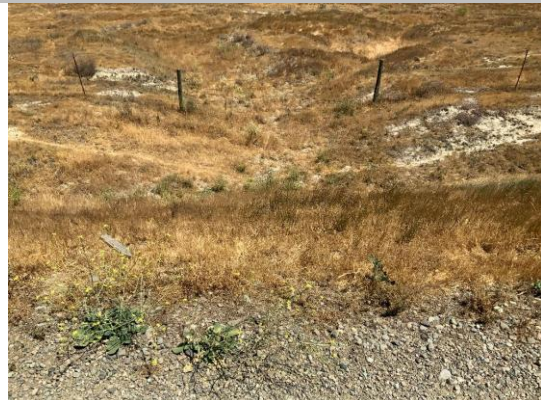
Comment Code						
Inspector Comment						
FS_ID:71166						
DS_ID:19893						
EP_NO: N/A						
Repair Type: Non-Urgent						
Crossing Status: Found						
UCIP Comments: 06/2/2021 The record has been upgraded from No Action Needed to Non-Urgent. DWR DMP internal inspection has not found pipe integrity issues. LOF of crossing is less or equal to 4.0. Recommend next video inspection in 5 years. No permit was found authorizing this encroachment. CVFPB will need to review crossing to determine owner. The UCIP inspection was completed with GEI staff, P. Espinoza. (H. Dunn ? GEI)						
FIELD_STRUCT_DESC: 24-inch corrugated metal gravity drainage pipe (CMP) through the levee, 11.1 feet below the crown. Flap gate on the waterside (WS) end. Concrete headwall on the landside (LS) end. Concrete U-shaped headwall on the WS end. [Additional Reference(s): DWR Levee Log, 2002, (HLM 0.34). USACE San Joaquin O&M Manual, Unit No. 601, Part No. 1, 1967, Amended in 1978, Revised 20 June 1985, (HLM 0.33). DWR As-Built Specification No. 63-25, Sheet No. 11, 9 May 1963, (HLM 0.33)].

Levee crown looking downstream.

LS view: Toe from crown.

LS view: Slope and headwall at toe.

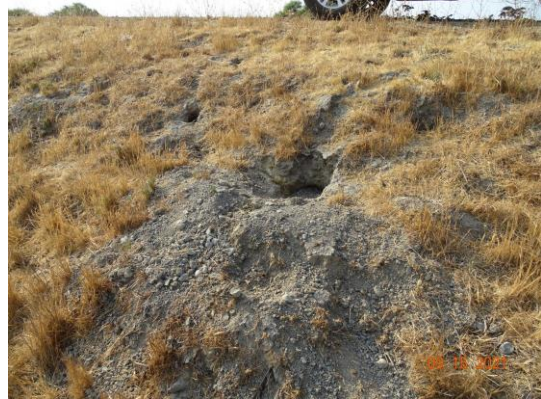
Photo 1 of 1 : SP_2022_NA0010_125_29_20220308_00011.jpg

LM Start	0.40	Rating **	M	Issue No.	29
LM End	0.50	Issue Type +	Ma	Location *	LS
Category	Earthen Levee			GPS Latitude/Longitude	
				Start	End
Item	Animal Control			37.257786 °	37.258722 °
				-120.765855 °	-120.764867 °
DWR ID	DWR_NA0010_07_s_2012_29				
Comment Code					
A3 : No rodents visible, but rodent burrows visible; need to backfill and compact or grout burrows.					
Inspector Comment					
Several rodent holes were noted on the landside and waterside slope and shoulder.

Looking at representative rodent hole in the landside slope. (Fall 2021)

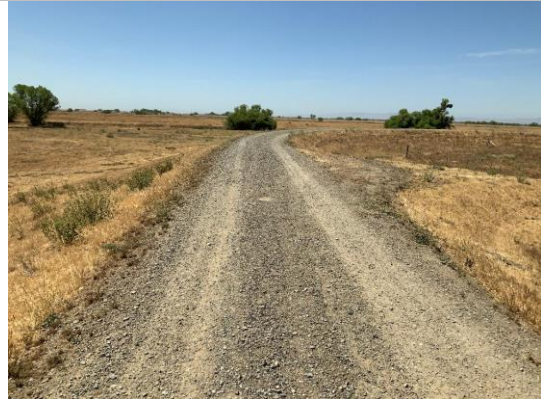
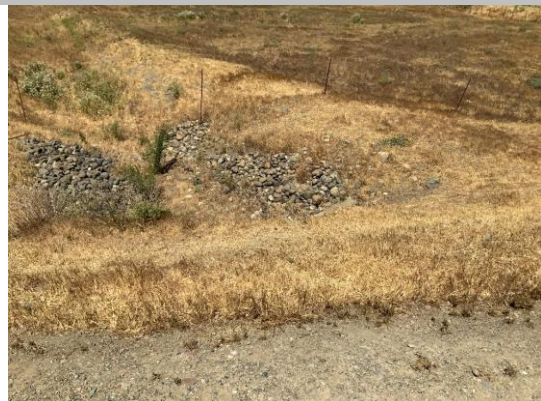
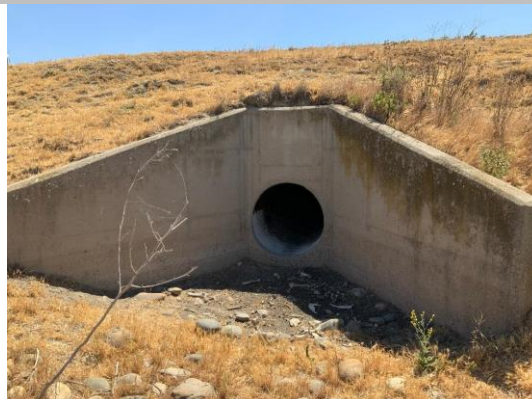
Comment Code						
Inspector Comment						
FS_ID:71167 DS_ID:19894 EP_NO: N/A Repair Type: Non-Urgent Crossing Status: Found UCIP Comments: 06/2/2021 Record remains Non-Urgent. No cover over the WS metal riser. There is debris and wood pallets within the riser that may prevent the ability for the slidegate to be opened or water to flow through, recommend cleaning out. DWR DMP internal inspection has not found pipe integrity issues. LOF of crossing is less or equal to 4.0. Recommend next video inspection in 5 years. No permit was found authorizing this encroachment. CVFPB will need to review crossing to determine owner. The UCIP inspection was completed with GEI staff, P. Espinoza. (H. Dunn ? GEI) 04/15/2014 Slide gate not operable, but left in closed position. Need to reinstall covers over slide gate standpipe. (W. Wylie - DWR UCIP) FIELD_STRUCT_DESC: 36-inch corrugated metal gravity drainage pipe (CMP) through the levee, 9.7 feet below the crown. Slide gate in a 48-inch CMP riser unit on the landside (LS) slope. Concrete U-shaped headwall on the LS end. Inlet channel cobble revetted. Dilapidated wooden pier on the waterside (WS). WS slope and outlet ditch cobble revetted. [Additional Reference(s): DWR Levee Log, 2002, (HLM 0.49). USACE San Joaquin O&M Manual, Unit No. 601, Part No. 1, 1967, Amended in 1978, Revised 20 June 1985, (HLM 0.49). DWR As-Built Specification No. 63-25, Sheet No. 11, 9 May 1963, (HLM 0.49)]. FS Date: 6/2/2021

Levee crown looking downstream.

LS view: Toe from crown.

LS view: Slope and headwall at toe.

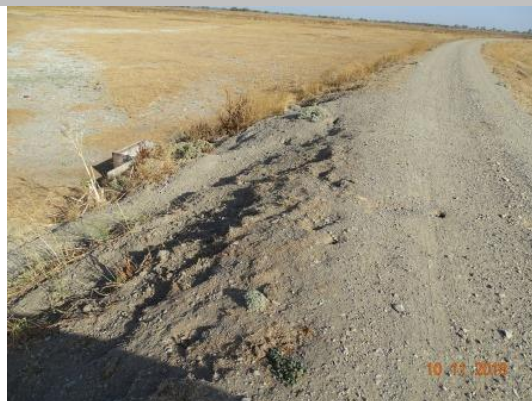
Photo 1 of 1 : SP_2022_NA0010_125_18_20220308_00006.jpg

LM Start	0.53	Rating **	A/W	Issue No.	18
LM End	0.53	Issue Type +	Ma	Location *	LS
Category	Earthen Levee			GPS Latitude/Longitude	
				Start	End
Item	Erosion / Livestock			37.259097 °	37.259097 °
				-120.764846 °	-120.764846 °
DWR ID	DWR_NA0010_07_f_2018_18				
Comment Code					
E4 : Repair the levee slope damaged by livestock and prevent large animal access.					
Inspector Comment					
There is livestock damage to the landside slope.

View of damage from livestock looking upstream. (Fall 2018)

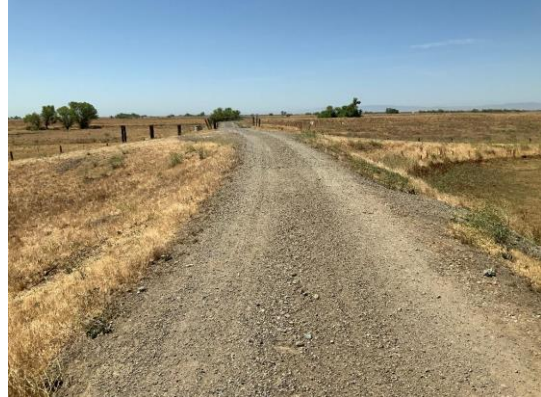
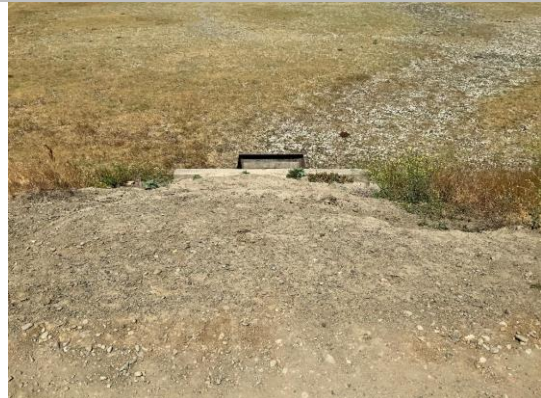
Comment Code						
Inspector Comment						
FS_ID:71168 DS_ID:19895 EP_NO: N/A Repair Type: Non-Urgent Crossing Status: Found UCIP Comments: 06/2/2021 The record has been upgraded from No Action Needed to Non-Urgent. DWR DMP internal inspection has not found pipe integrity issues. LOF of crossing is less or equal to 4.0. Recommend next video inspection in 5 years. There are plywood barriers on both WS and LS pipe ends, but no flapgate on either, and flapgate removed on WS. No permit was found authorizing this encroachment. CVFPB will need to review crossing to determine owner. The UCIP inspection was completed with GEI staff, P. Espinoza. (H. Dunn ? GEI) FIELD_STRUCT_DESC: 24-inch corrugated metal gravity drainage pipe (CMP) through the levee, 9.0 feet below the crown. Flap gate on the waterside (WS) end. Concrete headwall with a wooden weir at the inlet on the landside (LS) toe. Concrete U-shaped headwall on the WS toe. [Additional Reference(s): DWR Levee Log, 2002, (HLM 0.53). USACE San Joaquin O&M Manual, Unit No. 601, Part No. 1, 1967, Amended in 1978, Revised 20 June 1985, (HLM 0.53). DWR As-Built Specification No. 63-25, Sheet No. 11, 9 May 1963, (HLM 0.53)]. FS Date: 6/2/2021

Levee crown looking downstream.

LS view: Headwall visible at toe from crown.

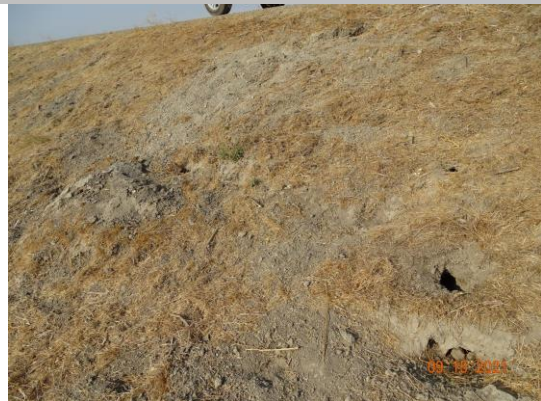
Photo 1 of 1 : SP_2022_NA0010_125_23_20220308_00010.jpg

LM Start	0.56	Rating **	M	Issue No.	23
LM End	0.56	Issue Type +	Ma	Location *	WS
Category	Earthen Levee			GPS Latitude/Longitude	
				Start	End
Item	Animal Control			37.259579 °	37.259579 °
				-120.764687 °	-120.764687 °
DWR ID	DWR_NA0010_07_f _ 2021_23				
Comment Code					
A1 : Exterminate rodents and backfill and compact or grout burrows.					
Inspector Comment

Looking at rodent burrows along the waterside slope. (Fall 2021)

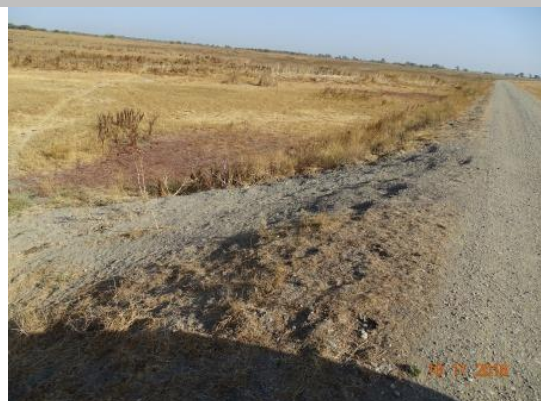
Photo 1 of 1 : SP_2022_NA0010_125_19_20220308_00007.jpg

LM Start	0.70	Rating **	A/W	Issue No.	19
LM End	0.70	Issue Type +	Ma	Location *	LS
Category	Earthen Levee			GPS Latitude/Longitude	
				Start	End
Item	Erosion / Livestock			37.261337 °	37.261337 °
				-120.763303 °	-120.763303 °
DWR ID	DWR_NA0010_07_f _ 2018_19				
Comment Code					
E4 : Repair the levee slope damaged by livestock and prevent large animal access.					
Inspector Comment					
There is livestock damage to the landside slope.

Damage to landside slope from livestock. (Fall 2018)

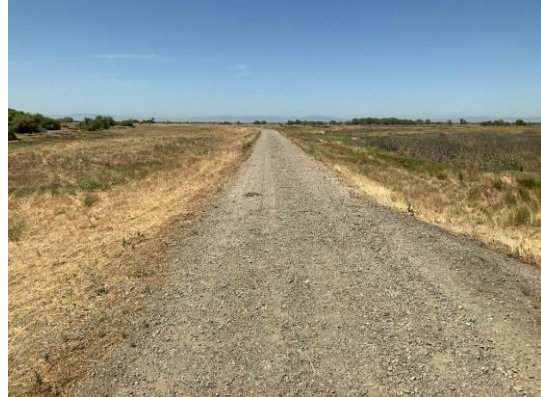
Photo 1 of 3 : UCIP_SP_2022_71169_99467.jpg

FS_ID:71169
DS_ID:19896
EP_NO: N/A
Repair Type: Non-Urgent
Crossing Status: Found
UCIP Comments: 06/2/2021 Record remains Non-Urgent. No permit was found authorizing this encroachment. CVFPB will need to review crossing to determine owner. Limited inspection due to water flowing through the pipe during inspection. At the time of inspection, the wooden flashboards were not in place on the LS end. The UCIP inspection was completed with GEI staff, P. Espinoza. (H. Dunn ? GEI)

LM Start	0.85	Rating **	M	Issue No.	8 (cont)
LM End	0.85	Issue Type +	Ma	Location *

Levee crown looking downstream.

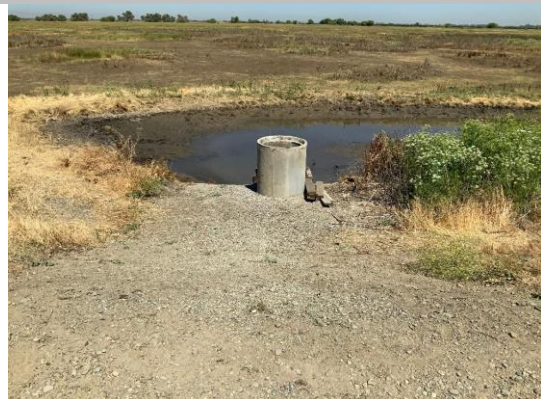
Photo 2 of 3 : UCIP_SP_2022_71169_99471.jpg

LS view: Riser visible at toe from crown.

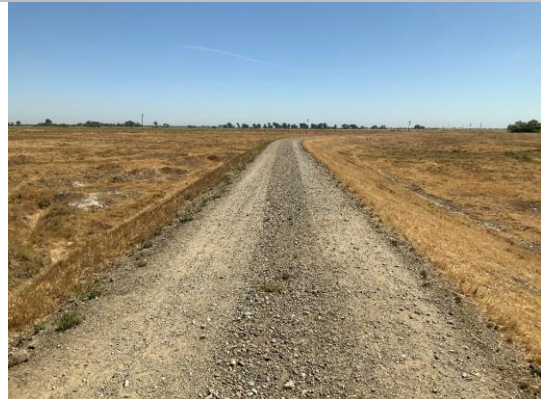
Photo 1 of 3 : UCIP_SP_2022_71170_99474.jpg

LM Start	0.94	Rating **	M	Issue No.	9
LM End	0.94	Issue Type +	Ma	Location *	
Category	Supplemental		GPS Latitude/Longitude		
			Start	End	
Item	DWR UCIP LMA Responsibility		37.263950 °	37.263950 °	
			-120.760572 °	-120.760572 °	
DWR ID	19897

FS_ID:71170
DS_ID:19897
EP_NO: N/A
Repair Type: Non-Urgent
Crossing Status: Found
UCIP Comments: 06/2/2021 The record has been upgraded from No Action Needed to Non-Urgent. DWR DMP internal inspection has not found pipe integrity issues. LOF of crossing is less or equal to 4.0. Recommend next video inspection in 5 years. No permit was found authorizing this encroachment. CVFPB will need to review crossing to determine owner. The UCIP inspection was completed with GEI staff, P. Espinoza. (H. Dunn ? GEI)
FIELD_STRUCT_DESC: 24-inch corrugated metal gravity drainage pipe (CMP) through the levee, 11.5 feet below the crown. Flap gate on the waterside (WS) end. Concrete headwall on the landside (LS) end. Concrete U-shaped headwall on the WS end. [Additional Reference(s): DWR Levee Log, 2002, (HLM 0.94). USACE San Joaquin O&M Manual, Unit No. 601, Part No. 1, 1967, Amended in 1978, Revised 20 June 1985, (HLM 0.94). DWR As-Built Specification No. 63-25, Sheet No. 11, 9 May 1963, (HLM 0.94)].

Levee crown looking downstream.

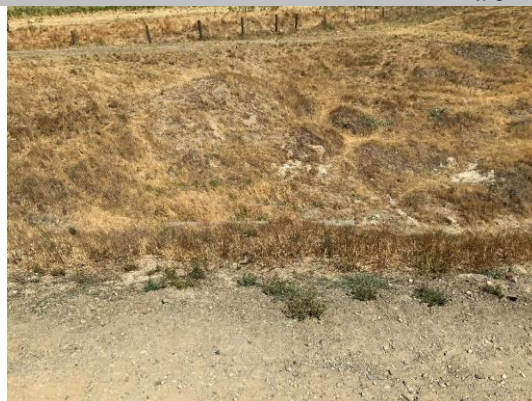
Photo 2 of 3 : UCIP_SP_2022_71170_99478.jpg

LM Start	0.94	Rating **	M	Issue No.	9 (cont)
LM End	0.94	Issue Type +	Ma	Location *	
Category	Supplemental		GPS Latitude/Longitude		
			Start	End	
Item	DWR UCIP LMA Responsibility		37.263950 °	37.263950 °	
			-120.760572 °	-120.760572 °	
DWR ID	19897

LS view: Toe from crown.

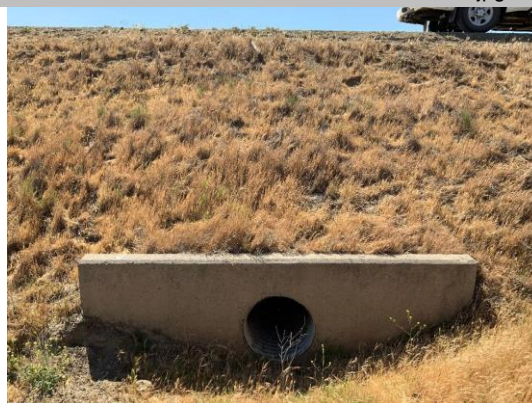
Photo 3 of 3 : UCIP_SP_2022_71170_99472.jpg

LM Start	0.94	Rating **	M	Issue No.	9 (cont)
LM End	0.94	Issue Type +	Ma	Location *

LS view: Slope and headwall at toe.

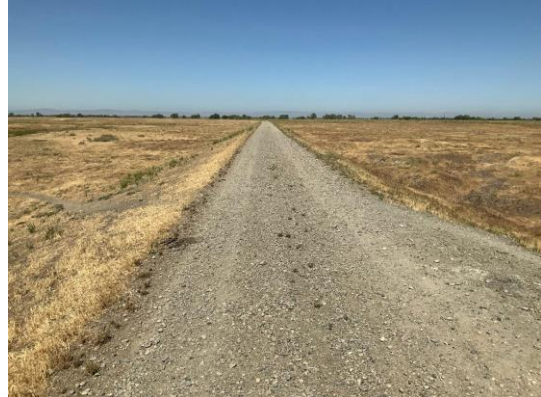
Photo 1 of 3 : UCIP_SP_2022_71171_99481.jpg

FS_ID:71171
DS_ID:19898
EP_NO: N/A
Repair Type: Non-Urgent
Crossing Status: Found
UCIP Comments: 06/2/2021 The record has been upgraded from No Action Needed to Non-Urgent. No permit was found authorizing this encroachment. CVFPB will need to review crossing to determine owner. The UCIP inspection was completed with GEI staff, P. Espinoza. (H. Dunn ? GEI)
FIELD_STRUCT_DESC: 48-inch corrugated metal gravity drainage pipe (CMP) through the levee, 14.6 feet below the crown. Flap gate on the waterside (WS) end. Concrete U-shaped headwall on each end.
[Additional Reference(s): DWR Levee Log, 2002, (HLM 1.17). USACE San Joaquin O&M Manual, Unit No. 601, Part No. 1, 1967, Amended in 1978, Revised 20 June 1985, (HLM 1.17). DWR As-Built Specification No. 63-25, Sheet No. 11, 9 May 1963, (HLM 1.17)].
FS Date: 6/2/2021

LM Start	1.17	Rating **	M	Issue No.	10 (cont)
LM End	1.17	Issue Type +	Ma	Location *

Levee crown looking downstream.

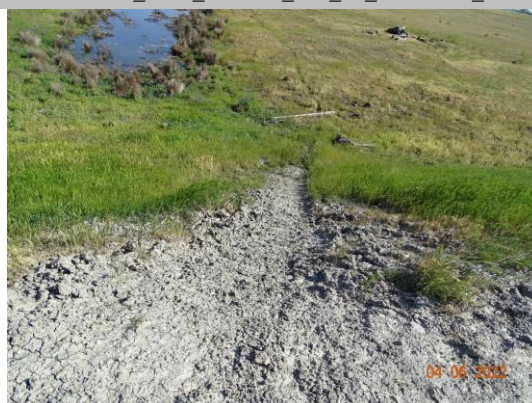
Photo 1 of 1 : SP_2022_NA0010_125_25_20220414_00045.jpg

LM Start	1.24	Rating **	A/W	Issue No.	25
LM End	1.24	Issue Type +	Ma	Location *	LS
Category	Earthen Levee			GPS Latitude/Longitude	
				Start	End
Item	Erosion / Livestock			37.264365 °	37.264365 °
				-120.755358 °	-120.755358 °
DWR ID	DWR_NA0010_07_s_2022_25				
Comment Code					
E4 : Repair the levee slope damaged by livestock and prevent large animal access.					
Inspector Comment

Looking down the landside slope at erosion from livestock traffic. (Spring 2022)

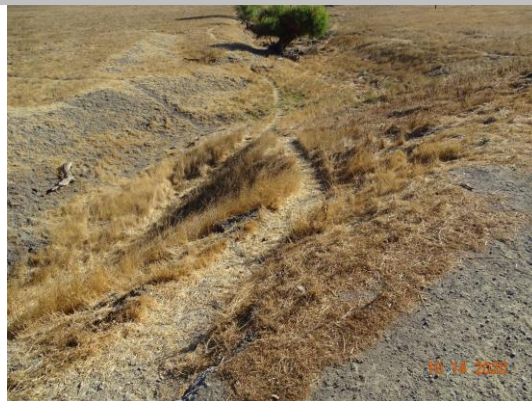
Photo 1 of 1 : SP_2022_NA0010_125_16_20220308_00004.jpg

LM Start	1.49	Rating **	A/W	Issue No.	16
LM End	1.49	Issue Type +	Ma	Location *	LS
Category	Earthen Levee			GPS Latitude/Longitude	
				Start	End
Item	Erosion / Livestock			37.263999 °	37.263999 °
				-120.750854 °	-120.750854 °
DWR ID	DWR_NA0010_07_f _ 2017_16				
Comment Code					
E4 : Repair the levee slope damaged by livestock and prevent large animal access.					
Inspector Comment					
Monitor the slope damaged by animal traffic.

Cattle trail on the landside slope. (Fall 2020)

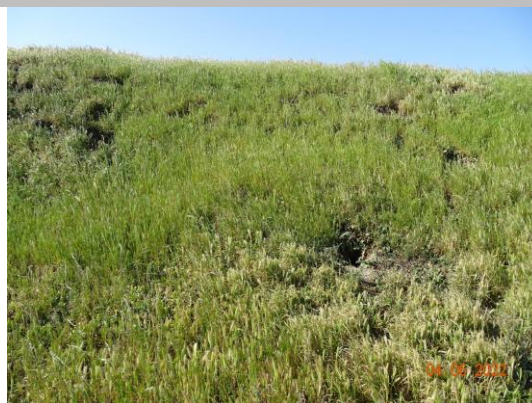
Photo 1 of 1 : SP_2022_NA0010_125_6_20220414_00046.jpg

LM Start	1.50	Rating **	M	Issue No.	6
LM End	1.51	Issue Type +	Ma	Location *	LS
Category	Earthen Levee			GPS Latitude/Longitude	
				Start	End
Item	Animal Control			37.263955 °	37.263885 °
				-120.750751 °	-120.750527 °
DWR ID	DWR_NA0010_07_s_2014_6				
Comment Code					
A1 : Exterminate rodents and backfill and compact or grout burrows.					
Inspector Comment

View of rodent holes on the landside slope. (Spring 2022)

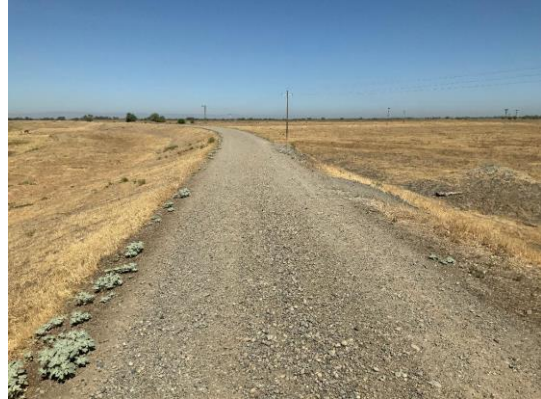
Photo 1 of 3 : UCIP_SP_2022_71172_99488.jpg

Comment Code						
Inspector Comment						
FS_ID:71172 DS_ID:19902 EP_NO: N/A Repair Type: Non-Urgent Crossing Status: Found UCIP Comments: 06/2/2021 The record has been upgraded from No Action Needed to Non-Urgent. DWR DMP internal inspection has not found pipe integrity issues. LOF of crossing is less or equal to 4.0. Recommend next video inspection in 5 years. No permit was found authorizing this encroachment. CVFPB will need to review crossing to determine owner. The UCIP inspection was completed with GEI staff, P. Espinoza. (H. Dunn ? GEI) FIELD_STRUCT_DESC: 24-inch corrugated metal gravity drainage pipe (CMP) through the levee, 14.0 feet below the crown. Flap gate on the waterside (WS) end. Concrete U-shaped headwall on each end. [Additional Reference(s): DWR Levee Log, 2002, (HLM 1.51). USACE San Joaquin O&M Manual, Unit No. 601, Part No. 1, 1967, Amended in 1978, Revised 20 June 1985, (HLM 1.51). DWR As-Built Specification No. 63-25, Sheet No. 12, 9 May 1963, (HLM 1.51)]. FS Date: 6/2/2021

LM Start	1.50	Rating **	M	Issue No.	11 (cont)
LM End	1.50	Issue Type +	Ma	Location *

Levee crown looking downstream.

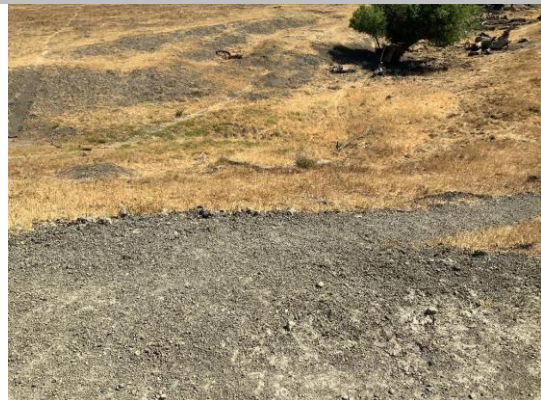
Photo 2 of 3 : UCIP_SP_2022_71172_99492.jpg

LS view: Toe from crown.
