**Flood Control Project Maintenance
Levee Inspections
LMA District Cover Sheet**

Lower San Joaquin Levee District

**Flood Control Project Maintenance
Levee Inspections
Unit Cover Sheet**

Levee Inspection Report By Mile - Spring 2022

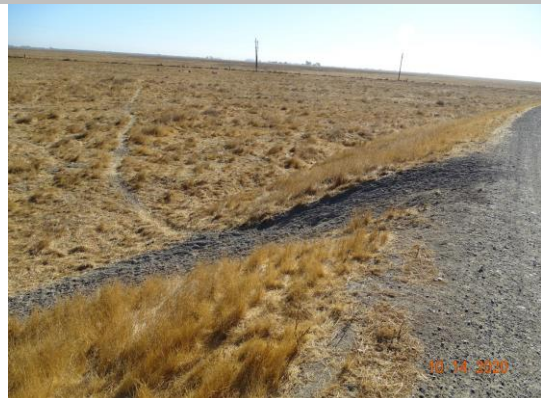
Photo 1 of 1 : SP_2022_NA0010_125_21_20220308_00008.jpg

LM Start	1.90	Rating **	M	Issue No.	21
LM End	1.90	Issue Type +	Ma	Location *	LS
Category	Earthen Levee			GPS Latitude/Longitude	
				Start	End
Item	Erosion / Livestock			37.261379 °	37.261379 °
				-120.744228 °	-120.744228 °
DWR ID	DWR_NA0010_07_f_2018_21				
Comment Code					
E4 : Repair the levee slope damaged by livestock and prevent large animal access.					
Inspector Comment

View of damage to the landside slope. (Fall 2020)

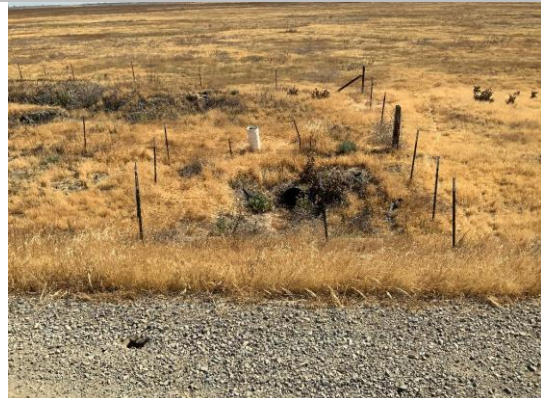
Photo 2 of 3 : UCIP_SP_2022_71173_99498.jpg

LS view: Toe from crown.

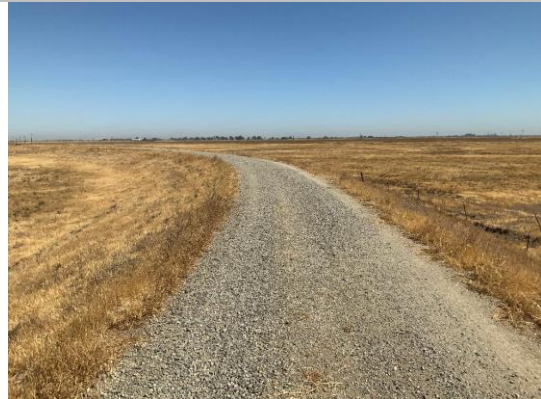
Photo 1 of 3 : UCIP_SP_2022_71174_99504.jpg

LM Start	2.63	Rating **	M	Issue No.	14
LM End	2.63	Issue Type +	Ma	Location *	
Category	Supplemental		GPS Latitude/Longitude		
			Start	End	
Item	DWR UCIP LMA Responsibility		37.254832 °	37.254832 °	
			-120.734918 °	-120.734918 °	
DWR ID	19900

FS_ID:71174
 DS_ID:19900
 EP_NO: N/A
 Repair Type: Non-Urgent
 Crossing Status: Found
 UCIP Comments: 06/2/2021 The record has been upgraded from No Action Needed to Non-Urgent. LS pipe end surrounded by barbed wire, inspection was limited. No permit was found authorizing this encroachment. CVFPB will need to review crossing to determine owner. The UCIP inspection was completed with GEI staff, P. Espinoza. (H. Dunn ? GEI)
 FIELD_STRUCT_DESC: 24-inch corrugated metal gravity drainage pipe (CMP) through the levee, 11.5 feet below the crown. Flap gate on the waterside (WS) end. Concrete headwall on the landside (LS) end. Concrete U-shaped headwall on the WS end. [Additional Reference(s): DWR Levee Log, 2002, (HLM 2.65). USACE San Joaquin O&M Manual, Unit No. 601, Part No. 1, 1967, Amended in 1978, Revised 20 June 1985, (HLM 2.64). DWR As-Built Specification No. 63-25, Sheet No. 12, 9 May 1963, (HLM 2.64)].

Levee crown looking downstream.

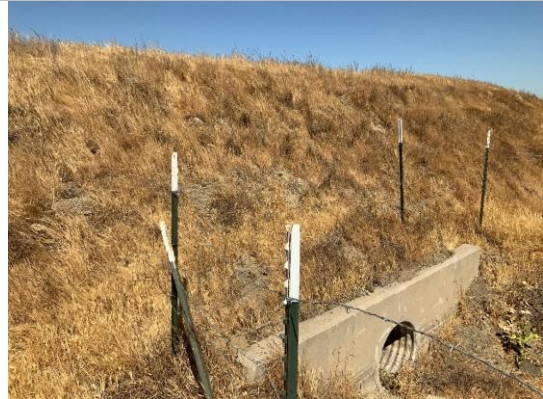
Photo 3 of 3 : UCIP_SP_2022_71174_99502.jpg

LM Start	2.63	Rating **	M	Issue No.	14 (cont)
LM End	2.63	Issue Type +	Ma	Location *

LS view: Slope and headwall at toe.

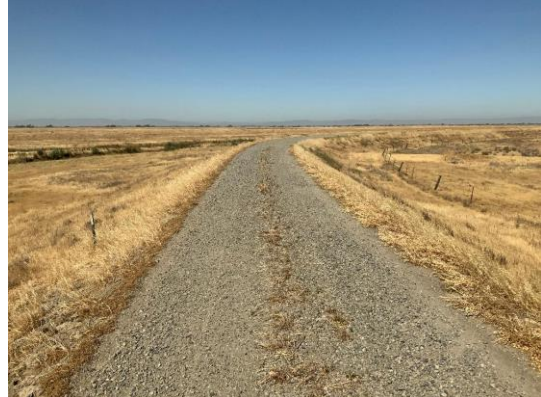
Photo 1 of 3 : UCIP_SP_2022_71175_99510.jpg

FS_ID:71175
DS_ID:19901
EP_NO: N/A
Repair Type: Non-Urgent
Crossing Status: Found
UCIP Comments: 06/2/2021 Record remains Non-Urgent. DWR DMP internal inspection has found pipe integrity issues. LOF of crossing is equal to 4.1 and less than 5. Crossing will be monitored until funding becomes available for rehabilitation. Some sediment buildup in the inlet of the pipe on the LS, recommend cleaning out. No permit was found authorizing this encroachment. CVFPB will need to review crossing to determine owner. The UCIP inspection was completed with GEI staff, P. Espinoza. (H. Dunn ? GEI) 04/15/2014 Some sediment buildup at landward toe and inside pipe--recommend clearing. (W. Wylie - DWR UCIP)
FIELD_STRUCT_DESC: 24-inch corrugated metal gravity drainage pipe (CMP) through the levee, 10.4 feet below the crown. Flap gate on the waterside (WS) end. Concrete headwall on the landside (LS) end. Concrete U-shaped headwall on the WS end. [Additional Reference(s): DWR Levee Log, 2002, (HLM 3.09). USACE San Joaquin O&M Manual, Unit No. 601, Part No. 1, 1967, Amended in 1978, Revised 20 June 1985, (HLM 3.09). DWR As-Built Specification No. 63-25, Sheet No. 13, 9 May 1963, (HLM 3.09)].

LM Start	3.09	Rating **	M	Issue No.	15 (cont)
LM End	3.09	Issue Type +	Ma	Location *

Levee crown looking downstream.

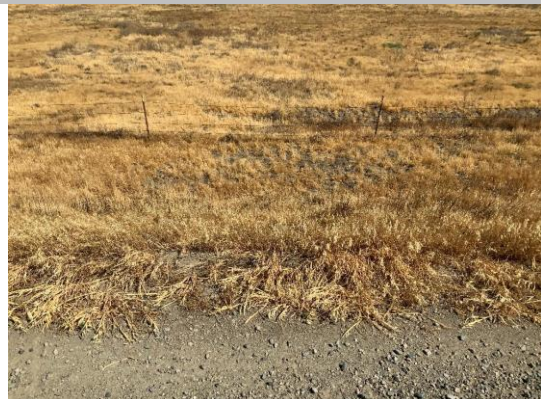
Photo 2 of 3 : UCIP_SP_2022_71175_99512.jpg

LS view: Toe from crown.

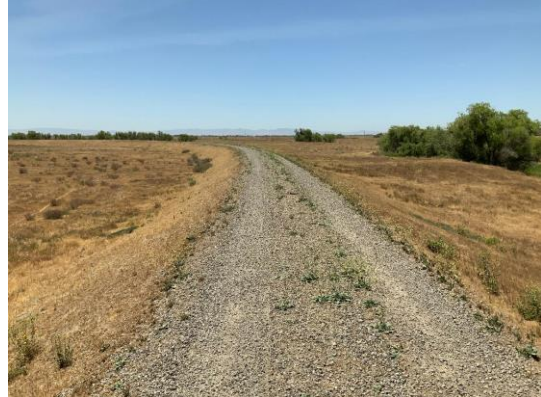
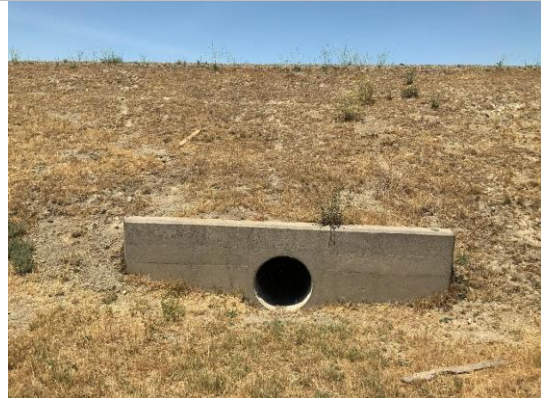
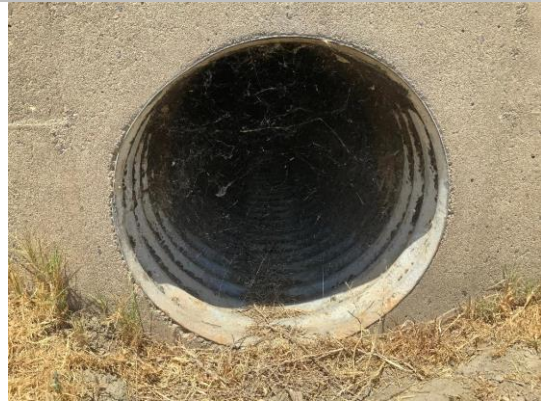
Comment Code						
Inspector Comment						
FS_ID:71177						
DS_ID:19903						
EP_NO: N/A						
Repair Type: Non-Urgent						
Crossing Status: Found						
UCIP Comments: 06/2/2021 The record has been upgraded from No Action Needed to Non-Urgent. DWR DMP internal inspection has not found pipe integrity issues. LOF of crossing is less or equal to 4.0. Recommend next video inspection in 5 years. No permit was found authorizing this encroachment. CVFPB will need to review crossing to determine owner. The UCIP inspection was completed with GEI staff, P. Espinoza. (H. Dunn ? GEI)						
FIELD_STRUCT_DESC: 24-inch corrugated metal gravity drainage pipe (CMP) through the levee, 9.6 feet below the crown. Flap gate on the waterside (WS) end. Concrete headwall on the landside (LS) end. Concrete U-shaped headwall on the WS end. [Additional Reference(s): DWR Levee Log, 2002, (HLM 0.23). USACE San Joaquin O&M Manual, Unit No. 601, Part No. 1, 1967, Amended in 1978, Revised 20 June 1985, (HLM 0.23). DWR As-Built Specification No. 63-25, Sheet No. 11, 9 May 1963, (HLM 0.23)].

Levee crown looking downstream.

LS view: Slope and headwall at toe.

LS view: Close up of pipe inlet at toe.

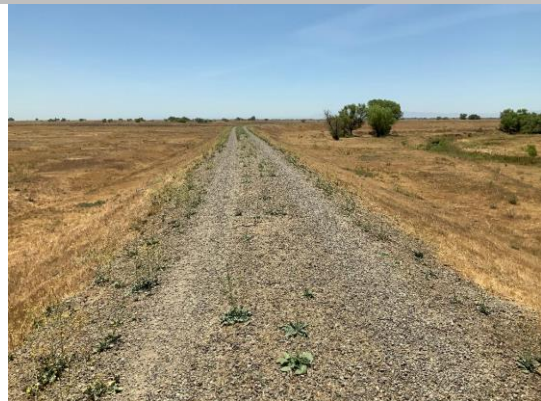
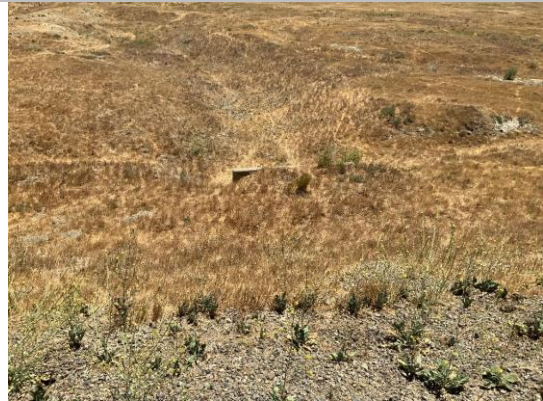
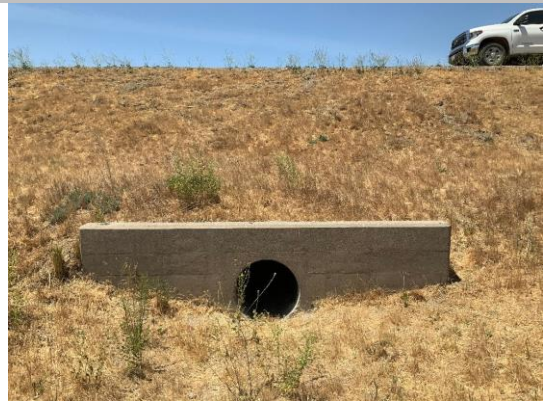
FS_ID:71178
DS_ID:19904
EP_NO: N/A
Repair Type: Non-Urgent
Crossing Status: Found
UCIP Comments: 06/2/2021 The record has been upgraded from No Action Needed to Non-Urgent. DWR DMP internal inspection has not found pipe integrity issues. LOF of crossing is less or equal to 4.0. Recommend next video inspection in 5 years. No permit was found authorizing this encroachment. CVFPB will need to review crossing to determine owner. The UCIP inspection was completed with GEI staff, P. Espinoza. (H. Dunn ? GEI)
FIELD_STRUCT_DESC: 24-inch corrugated metal gravity drainage pipe (CMP) through the levee, 12.4 feet below the crown. Flap gate on the waterside (WS) end. Concrete headwall on each end. [Additional Reference(s): DWR Levee Log, 2002, (HLM 0.55). USACE San Joaquin O&M Manual, Unit No. 601, Part No. 1, 1967, Amended in 1978, Revised 20 June 1985, (HLM 0.57). DWR As-Built Specification No. 63-25, Sheet No. 11, 9 May 1963, (HLM 0.57)].

Levee crown looking downstream.

LS view: Headwall visible at toe from crown.

LS view: Slope and headwall at toe.

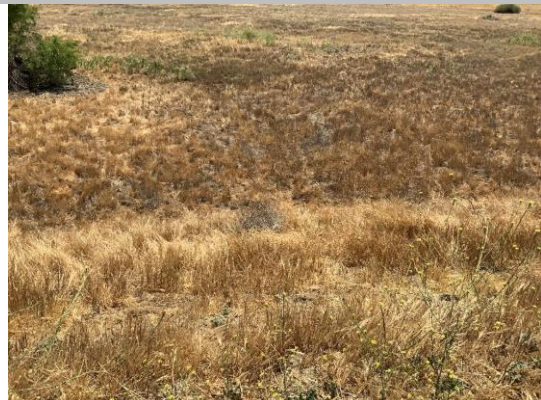
Comment Code						
Inspector Comment						
FS_ID:71179 DS_ID:19905 EP_NO: N/A Repair Type: Non-Urgent Crossing Status: Found UCIP Comments: 06/2/2021 The record has been upgraded from No Action Needed to Non-Urgent. DWR DMP internal inspection has not found pipe integrity issues. LOF of crossing is less or equal to 4.0. Recommend next video inspection in 5 years. No permit was found authorizing this encroachment. CVFPB will need to review crossing to determine owner. The UCIP inspection was completed with GEI staff, P. Espinoza. (H. Dunn ? GEI) FIELD_STRUCT_DESC: 24-inch corrugated metal gravity drainage pipe (CMP) through the levee, 10.0 feet below the crown. Flap gate on the waterside (WS) end. Concrete headwall on each end. [Additional Reference(s): DWR Levee Log, 2002, (HLM 0.70). USACE San Joaquin O&M Manual, Unit No. 601, Part No. 1, 1967, Amended in 1978, Revised 20 June 1985, (HLM 0.72). DWR As-Built Specification No. 63-25, Sheet No. 11, 9 May 1963, (HLM 0.72)]. FS Date: 6/2/2021

Levee crown looking downstream.

LS view: Toe from crown.

LS view: Slope and headwall at toe.

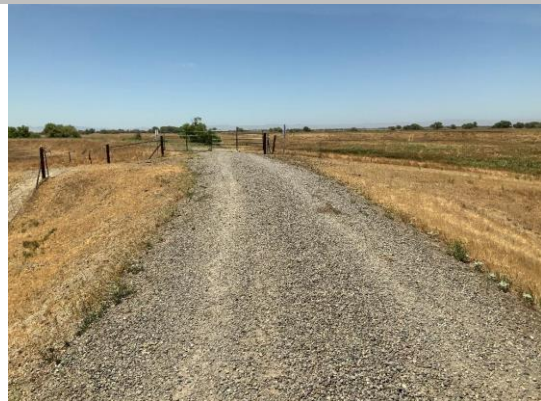
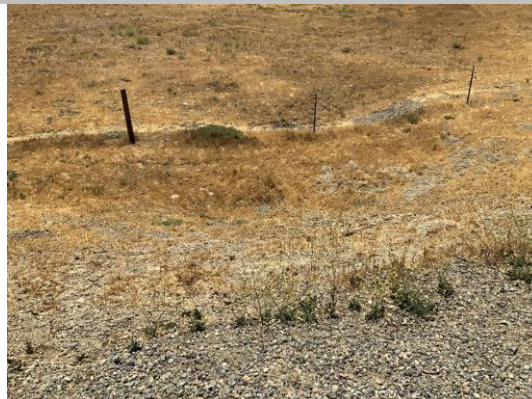
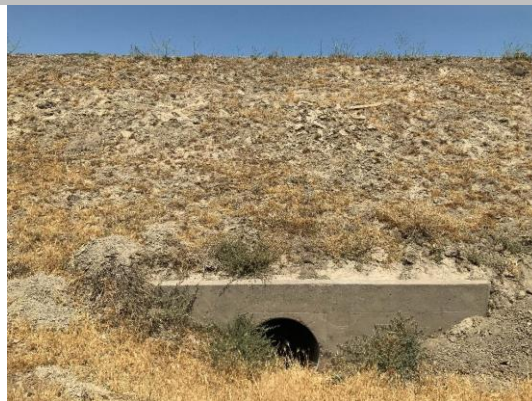
FS_ID:71180
DS_ID:19832
EP_NO: N/A
Repair Type: Non-Urgent
Crossing Status: Found
UCIP Comments: 06/2/2021 Record remains Non-Urgent. DWR DMP internal inspection has not found pipe integrity issues. LOF of crossing is less or equal to 4.0. Recommend next video inspection in 5 years. No permit was found authorizing this encroachment. CVFPB will need to review crossing to determine owner. The UCIP inspection was completed with GEI staff, P. Espinoza. (H. Dunn ? GEI) 04/16/2014 Some sediment buildup at inlet on LS toe. (W. Wylie - DWR UCIP) FIELD_STRUCT_DESC: 24-inch corrugated metal gravity drainage pipe (CMP) through the levee, 11.5 feet below the crown. Flap gate on the waterside (WS) end. Concrete headwall on each end. [Additional Reference(s): DWR Levee Log, 2002, (HLM 0.88). USACE San Joaquin O&M Manual, Unit No. 601, Part No. 1, 1967, Amended in 1978, Revised 20 June 1985, (HLM 0.89). DWR As-Built Specification No. 63-25, Sheet No. 11, 9 May 1963, (HLM 0.89)].

Levee crown looking downstream.

LS view: Toe from crown.

LS view: Slope and headwall at toe.

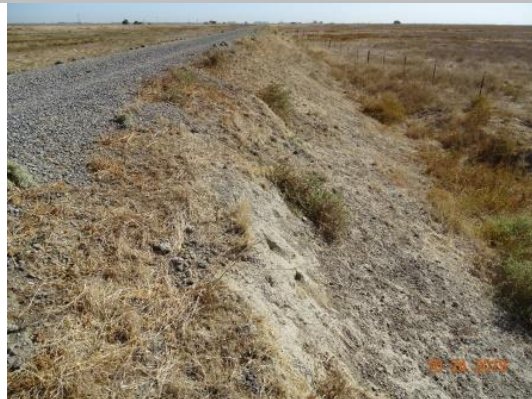
Photo 1 of 1 : SP_2022_NA0010_126_28_20220308_00007.jpg

View of slope damage on the landside of the levee looking upstream.
(Fall 2019)

LM Start	1.21	Rating **	M	Issue No.	28
LM End	1.21	Issue Type +	Ma	Location *	LS
Category	Earthen Levee			GPS Latitude/Longitude	
				Start	End
Item	Erosion / Livestock			37.263179 °	37.263179 °
				-120.755444 °	-120.755444 °
DWR ID	DWR_NA0010_08_f_2019_28				
Comment Code					
E4 : Repair the levee slope damaged by livestock and prevent large animal access.					
Inspector Comment

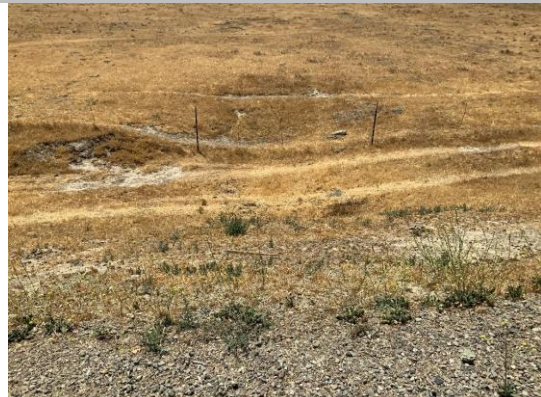
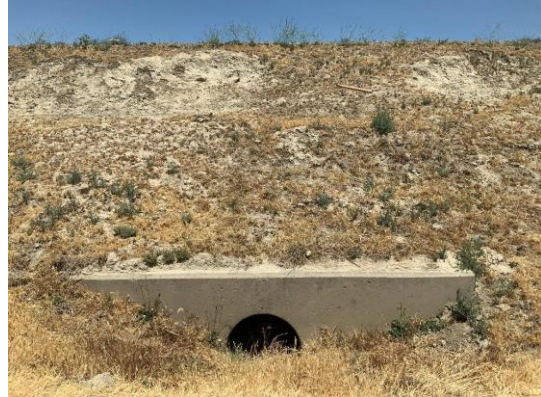
Comment Code						
Inspector Comment						
FS_ID:71181 DS_ID:19833 EP_NO: N/A Repair Type: Non-Urgent Crossing Status: Found UCIP Comments: 06/2/2021 Record remains Non-Urgent. Some vegetation in LS pipe inlet, recommend clearing out. DWR DMP internal inspection has not found pipe integrity issues. LOF of crossing is less or equal to 4.0. Recommend next video inspection in 5 years. No permit was found authorizing this encroachment. CVFPB will need to review crossing to determine owner. The UCIP inspection was completed with GEI staff, P. Espinoza. (H. Dunn ? GEI) 04/16/2014 Debris blocking landward headwall--recommend clearing. (W. Wylie - DWR UCIP) FIELD_STRUCT_DESC: 24-inch corrugated metal gravity drainage pipe (CMP) through the levee, 11.6 feet below the crown. Flap gate on the waterside (WS) end. Concrete headwall on each end. [Additional Reference(s): DWR Levee Log, 2002, (HLM 1.20). USACE San Joaquin O&M Manual, Unit No. 601, Part No. 1, 1967, Amended in 1978, Revised 20 June 1985, (HLM 1.21). DWR As-Built Specification No. 63-25, Sheet No. 11, 9 May 1963, (HLM 1.21)]. FS Date: 6/2/2021

Levee crown looking downstream.

LS view: Toe from crown.

LS view: Slope and headwall at toe.

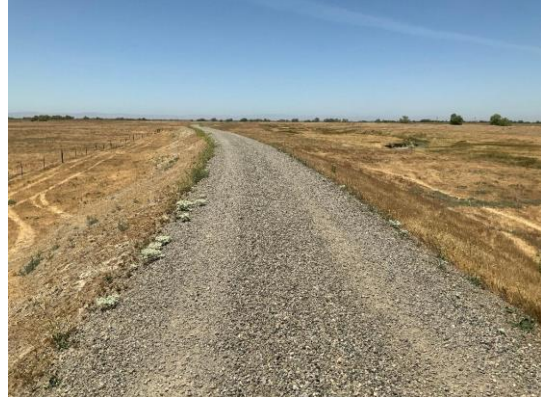
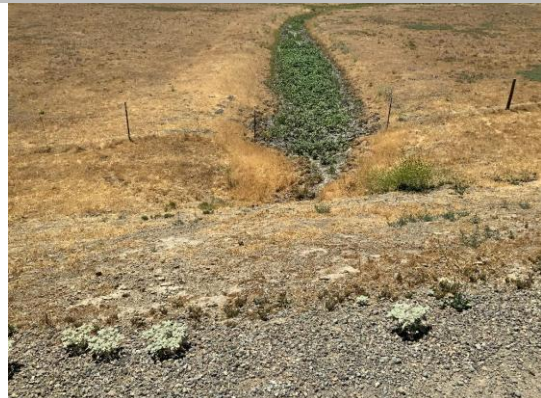
Comment Code					
Inspector Comment					
FS_ID:71182 DS_ID:19834 EP_NO: N/A Repair Type: Non-Urgent Crossing Status: Found UCIP Comments: 06/2/2021 Record remains Non-Urgent. Vegetation sticking out of WS flapgate, recommend removal. DWR DMP internal inspection has not found pipe integrity issues. LOF of crossing is less or equal to 4.0. Recommend next video inspection in 5 years. No permit was found authorizing this encroachment. CVFPB will need to review crossing to determine owner. The UCIP inspection was completed with GEI staff, P. Espinoza. (H. Dunn ? GEI) 04/16/2014 Animal burrows along pipe alignment on LS. Some sediment buildup at LS toe and inside pipe--recommend clearing. (W. Wylie -DWR UCIP) FIELD_STRUCT_DESC: 24-inch corrugated metal gravity drainage pipe (CMP) through the levee, 11.5 feet below the crown. Flap gate on the waterside (WS) end. Concrete headwall on each end. [Additional Reference(s): DWR Levee Log, 2002, (HLM 1.37). USACE San Joaquin O&M Manual, Unit No. 601, Part No. 1, 1967, Amended in 1978, Revised 20 June 1985, (HLM 1.38). DWR As-Built Specification No. 63-25, Sheet No. 12, 9 May 1963, (HLM 1.38)]. FS Date: 6/2/2021

Levee crown looking downstream.

LS view: Toe from crown.

LS view: Slope and headwall at toe.

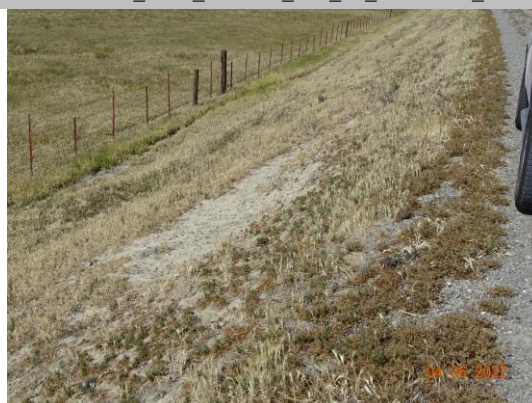
Photo 1 of 1 : SP_2022_NA0010_126_26_20220414_00044.jpg

Looking downstream at erosion spot on the landside slope. (Spring 2022)

LM Start	1.81	Rating **	M	Issue No.	26
LM End	1.81	Issue Type +	Ma	Location *	LS
Category	Earthen Levee			GPS Latitude/Longitude	
				Start	End
Item	Erosion / Livestock			37.260673 °	37.260673 °
				-120.745290 °	-120.745290 °
DWR ID	DWR_NA0010_08_f_2019_26				
Comment Code					
E4 : Repair the levee slope damaged by livestock and prevent large animal access.					
Inspector Comment

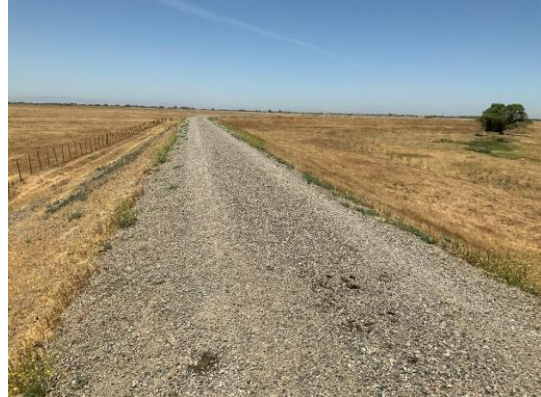
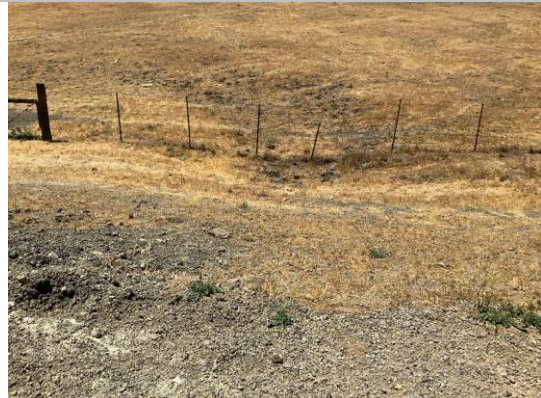
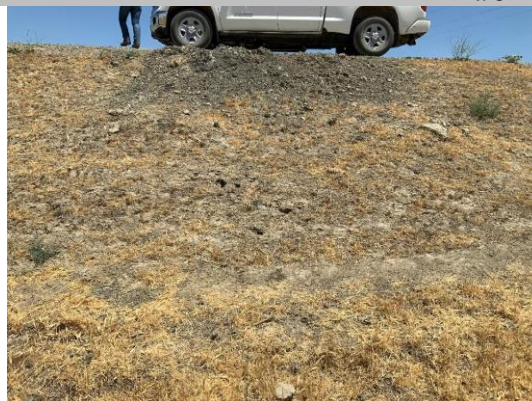
Comment Code						
Inspector Comment						
FS_ID:71183 DS_ID:19835 EP_NO: N/A Repair Type: Non-Urgent Crossing Status: Found UCIP Comments: 06/2/2021 Record remains Non-Urgent. LS pipe end not visible at all, appears to be buried or removed. Need to contact owner to determine status of pipe. DWR DMP internal inspection has not found pipe integrity issues. LOF of crossing is less or equal to 4.0. Recommend next video inspection in 5 years. No permit was found authorizing this encroachment. CVFPB will need to review crossing to determine owner. The UCIP inspection was completed with GEI staff, P. Espinoza. (H. Dunn ? GEI) 04/16/2014 Non-functional landward inlet is buried in sediment. Need to contact owner to determine status. (W. Wylie - DWR UCIP) FIELD_STRUCT_DESC: 24-inch corrugated metal gravity drainage pipe (CMP) through the levee, 12.0 feet below the crown. Flap gate on the waterside (WS) end. Concrete headwall on each end. [Additional Reference(s): DWR Levee Log, 2002, (HLM 2.04). USACE San Joaquin O&M Manual, Unit No. 601, Part No. 1, 1967, Amended in 1978, Revised 20 June 1985, (HLM 2.05). DWR As-Built Specification No. 63-25, Sheet No. 12, 9 May 1963, (HLM 2.05)]. FS Date: 6/2/2021

Levee crown looking downstream.

LS view: Toe from crown, no pipe visible.

LS view: Slope from toe, no pipe visible.

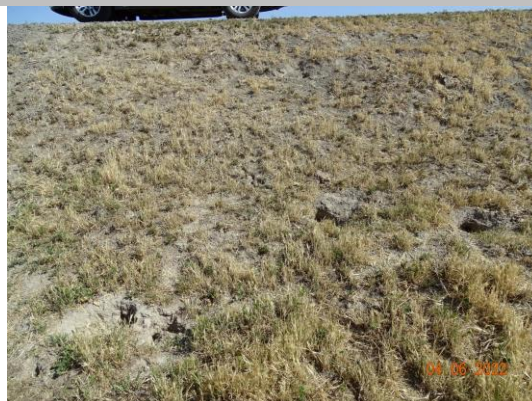
Photo 1 of 1 : SP_2022_NA0010_126_25_20220414_00045.jpg

Looking uphill at rodent holes in the landside slope. (Spring 2022)

LM Start	2.07	Rating **	M	Issue No.	25
LM End	2.07	Issue Type +	Ma	Location *	LS
Category	Earthen Levee			GPS Latitude/Longitude	
				Start	End
Item	Animal Control			37.258059 °	37.258059 °
				-120.742451 °	-120.742451 °
DWR ID	DWR_NA0010_08_f_2019_25				
Comment Code					
A1 : Exterminate rodents and backfill and compact or grout burrows.					
Inspector Comment

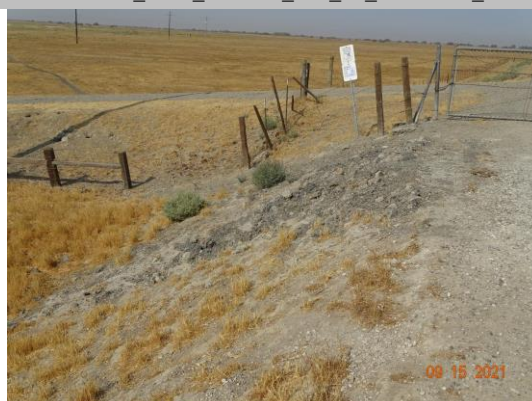
Photo 1 of 1 : SP_2022_NA0010_126_22_20220308_00005.jpg

LM Start	2.07	Rating **	A/W	Issue No.	22
LM End	2.07	Issue Type +	Ma	Location *	LS
Category	Earthen Levee			GPS Latitude/Longitude	
				Start	End
Item	Erosion / Livestock			37.258076 °	37.258076 °
				-120.742439 °	-120.742439 °
DWR ID	DWR_NA0010_08_f_2018_22				
Comment Code					
E4 : Repair the levee slope damaged by livestock and prevent large animal access.					
Inspector Comment					
Erosion from livestock has been repaired. Monitor for settlement.

Repaired slope damage should be monitored for settlement. (Fall 2021)

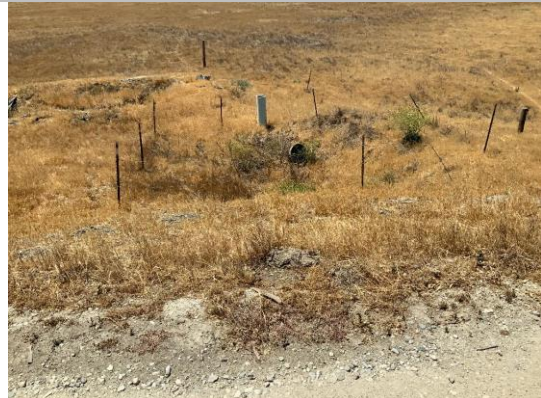
Comment Code						
Inspector Comment						
FS_ID:71184 DS_ID:19836 EP_NO: N/A Repair Type: Non-Urgent Crossing Status: Found UCIP Comments: 06/2/2021 The record remains Non-Urgent. DWR DMP internal inspection has not found pipe integrity issues. LOF of crossing is less or equal to 4.0. Recommend next video inspection in 5 years. New 6 inch plastic riser with flowmeter and 24 inch metal pipe underground off the LS toe, directly opposite of the LS pipe inlet of this DSID. No permit was found authorizing this encroachment. CVFPB will need to review crossing to determine owner. The UCIP inspection was completed with GEI staff, P. Espinoza. (H. Dunn ? GEI) 04/16/2014 Sediment buildup in pipe visible from landward side. (W. Wylie - DWR UCIP) FIELD_STRUCT_DESC: 24-inch corrugated metal gravity drainage pipe (CMP) through the levee, 9.5 feet below the crown. Flap gate on the waterside (WS) end. Concrete headwall on each end. [Additional Reference(s): DWR Levee Log, 2002, (HLM 2.12). USACE San Joaquin O&M Manual, Unit No. 601, Part No. 1, 1967, Amended in 1978, Revised 20 June 1985, (HLM 2.12). DWR As-Built Specification No. 63-25, Sheet No. 12, 9 May 1963, (HLM 2.12)]. FS Date: 6/2/2021

Levee crown looking downstream.

LS view: Toe from crown.

LS view: Slope and headwall at toe.

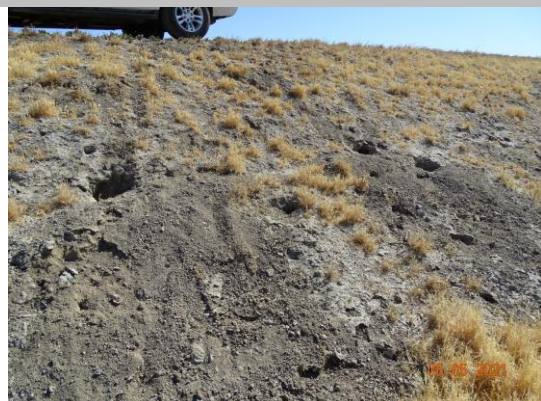
Photo 1 of 1 : SP_2022_NA0010_126_18_20220308_00003.jpg

View of rodent holes in the landside slope. (Spring 2021)

LM Start	2.29	Rating **	M	Issue No.	18
LM End	2.43	Issue Type +	Ma	Location *	LS
Category	Earthen Levee			GPS Latitude/Longitude	
				Start	End
Item	Animal Control			37.256251 °	37.254767 °
				-120.739280 °	-120.737772 °
DWR ID	DWR_NA0010_08_s_2021_18				
Comment Code					
A1 : Exterminate rodents and backfill and compact or grout burrows.					
Inspector Comment

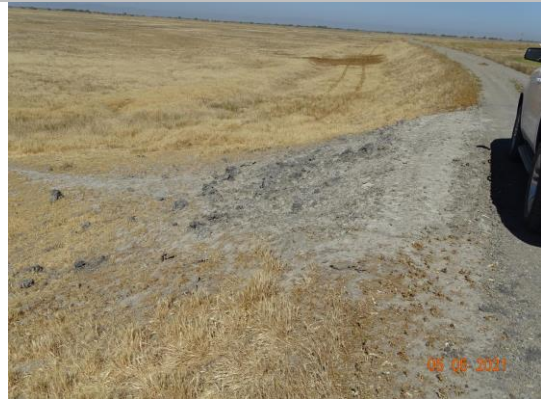
Photo 1 of 1 : SP_2022_NA0010_126_20_20220308_00004.jpg

LM Start	2.74	Rating **	A/W	Issue No.	20
LM End	2.74	Issue Type +	Ma	Location *	LS
Category	Earthen Levee			GPS Latitude/Longitude	
				Start	End
Item	Erosion / Livestock			37.252503 °	37.252503 °
				-120.733282 °	-120.733282 °
DWR ID	DWR_NA0010_08_f _ 2018_20				
Comment Code					
E4 : Repair the levee slope damaged by livestock and prevent large animal access.					
Inspector Comment					
Erosion from livestock has been repaired. Monitor for settlement.

View of repaired slope damage. (Spring 2021)

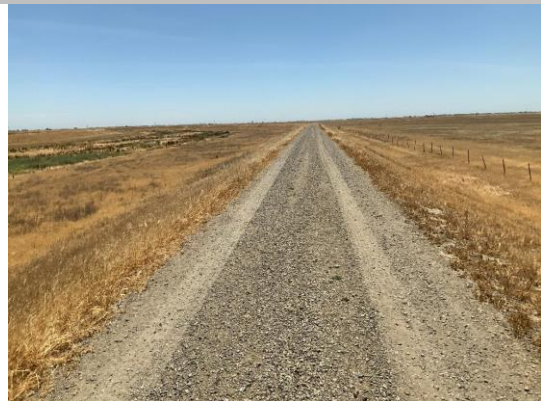
LM Start	2.77	Rating **	M	Issue No.	11
LM End	2.77	Issue Type +	Ma	Location *	
Category	Supplemental			GPS Latitude/Longitude	
				Start	End
Item	DWR UCIP LMA Responsibility			37.252228 °	37.252228 °
				-120.732890 °	-120.732890 °
DWR ID	19837

Comment Code					
Inspector Comment					
FS_ID:71185 DS_ID:19837 EP_NO: N/A Repair Type: Non-Urgent Crossing Status: Found UCIP Comments: 06/2/2021 The record has been upgraded from No Action Needed to Non-Urgent. DWR DMP internal inspection has not found pipe integrity issues. LOF of crossing is less or equal to 4.0. Recommend next video inspection in 5 years. No permit was found authorizing this encroachment. CVFPB will need to review crossing to determine owner. The UCIP inspection was completed with GEI staff, P. Espinoza. (H. Dunn ? GEI) FIELD_STRUCT_DESC: 24-inch corrugated metal gravity drainage pipe (CMP) through the levee, 10.5 feet below the crown. Flap gate on the waterside (WS) end. Concrete headwall on each end. [Additional Reference(s): DWR Levee Log, 2002, (HLM 2.77). USACE San Joaquin O&M Manual, Unit No. 601, Part No. 1, 1967, Amended in 1978, Revised 20 June 1985, (HLM 2.77). DWR As-Built Specification No. 63-25, Sheet No. 13, 9 May 1963, (HLM 2.77)]. FS Date: 6/2/2021

Levee crown looking downstream.

LS view: Toe from crown.

LS view: Slope and headwall at toe.

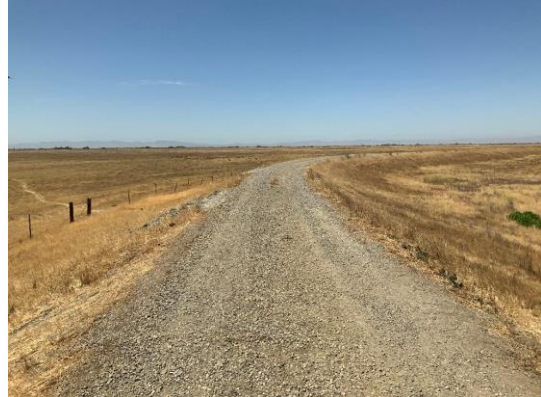
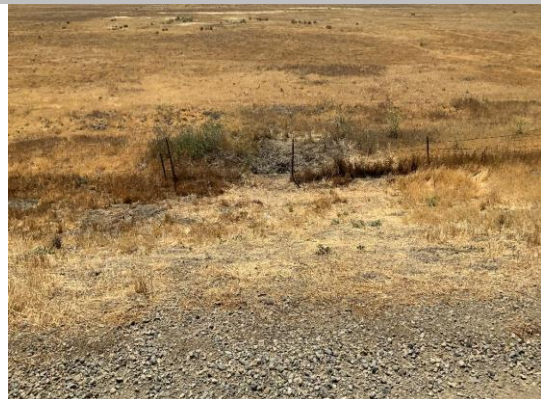
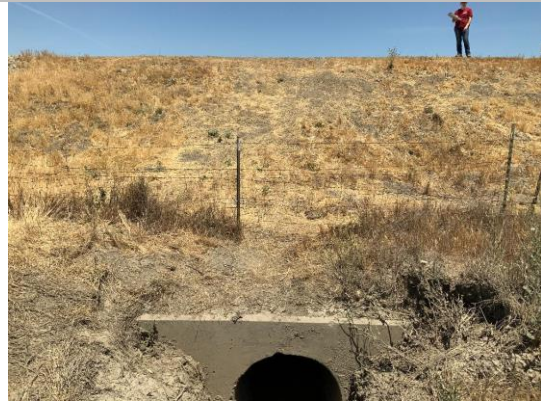
FS_ID:71186
DS_ID:19838
EP_NO: N/A
Repair Type: Non-Urgent
Crossing Status: Found
UCIP Comments: 06/2/2021 Record remains Non-Urgent. LS pipe inlet has some sediment buildup, recommend cleaning out. No permit was found authorizing this encroachment. CVFPB will need to review crossing to determine owner. The UCIP inspection was completed with GEI staff, P. Espinoza. (H. Dunn ? GEI) 7/20/2016 LS inlet buried under dense vegetation. Dense vegetation limits the inspector's visibility to identify signs of pipe failure (leaks) along the WS and LS slope. Recommend removing vegetation along pipe alignment to conduct proper inspection of structure and appurtenances. (O. Magana - DWR UCIP)4/16/2014 Pipe blocked by silt on LS toe. Flapgate rusty and does not operate correctly. (W. Wylie - DWR UCIP)
FIELD_STRUCT_DESC: 36-inch corrugated metal gravity drainage pipe (CMP) through the levee, 13.4 feet below the crown. Flap gate on the waterside (WS) end. Concrete headwall on each end. [Additional Reference(s): DWR Levee Log, 2002, (HLM 3.06). USACE San Joaquin O&M Manual, Unit No. 601, Part No. 1, 1967, Amended in 1978, Revised 20 June 1985, (HLM 3.06). DWR As-Built Specification No. 63-25, Sheet No. 13, 9 May 1963, (HLM 3.06)].

Levee crown looking downstream.

LS view: Toe from crown.

LS view: Slope and headwall at toe.

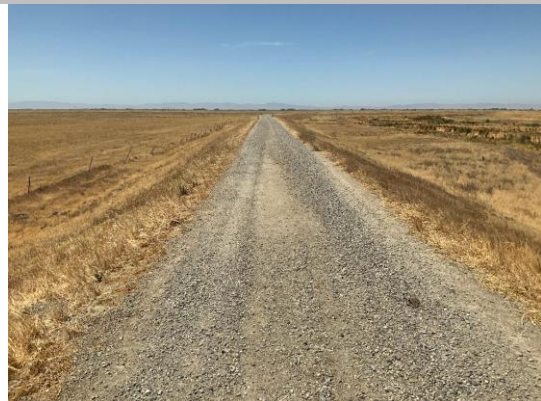
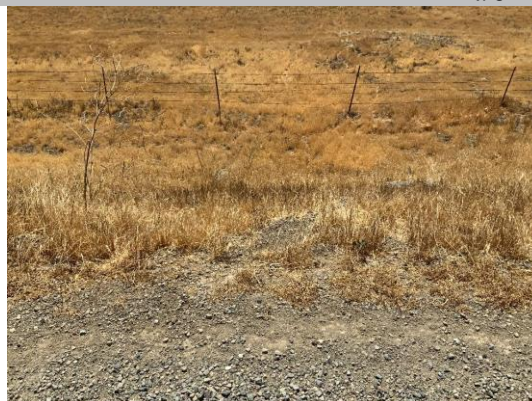
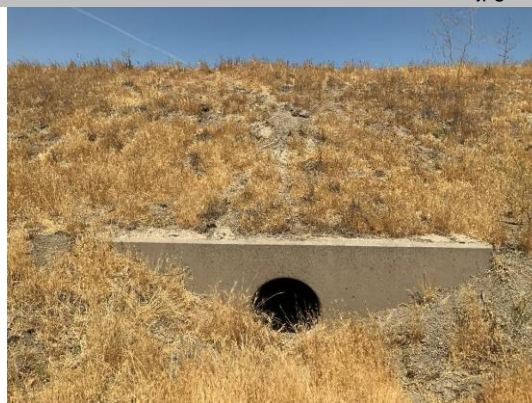
LM Start	3.24	Rating **	M	Issue No.	13
LM End	3.24	Issue Type +	Ma	Location *	
Category	Supplemental		GPS Latitude/Longitude		
			Start	End	
Item	DWR UCIP LMA Responsibility		37.252230 °	37.252230 °	
			-120.725504 °	-120.725504 °	
DWR ID	19839

FS_ID:71187
DS_ID:19839
EP_NO: N/A
Repair Type: Non-Urgent
Crossing Status: Found
UCIP Comments: 06/2/2021 The record has been upgraded from No Action Needed to Non-Urgent. DWR DMP internal inspection has not found pipe integrity issues. LOF of crossing is less or equal to 4.0. Recommend next video inspection in 5 years. No permit was found authorizing this encroachment. CVFPB will need to review crossing to determine owner. The UCIP inspection was completed with GEI staff, P. Espinoza. (H. Dunn ? GEI)
FIELD_STRUCT_DESC: 24-inch corrugated metal gravity drainage pipe (CMP) through the levee, 10.0 feet below the crown. Flap gate on the waterside (WS) end. Concrete headwall on each end. [Additional Reference(s): DWR Levee Log, 2002, (HLM 3.23). USACE San Joaquin O&M Manual, Unit No. 601, Part No. 1, 1967, Amended in 1978, Revised 20 June 1985, (HLM 3.24). DWR As-Built Specification No. 63-25, Sheet No. 13, 9 May 1963, (HLM 3.24)].

Levee crown looking downstream

LS view: Toe from crown.

LS view: Slope and headwall at toe.

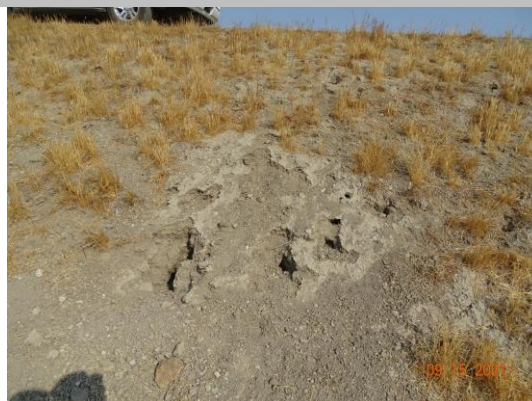
Photo 1 of 1 : SP_2022_NA0010_126_17_20220308_00002.jpg

LM Start	3.28	Rating **	M	Issue No.	17
LM End	3.28	Issue Type +	Ma	Location *	LS
Category	Earthen Levee			GPS Latitude/Longitude	
				Start	End
Item	Animal Control			37.252537 °	37.252537 °
				-120.724795 °	-120.724795 °
DWR ID	DWR_NA0010_08_f_2021_17				
Comment Code					
A3 : No rodents visible, but rodent burrows visible; need to backfill and compact or grout burrows.					
Inspector Comment

View of animal burrows in the landside slope. (Fall 2021)

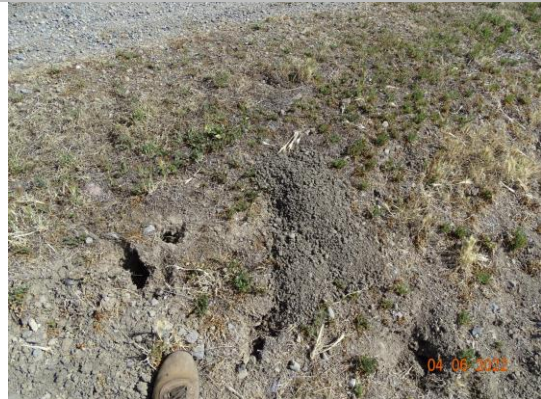
Photo 1 of 1 : SP_2022_NA0010_126_3_20220414_00046.jpg

LM Start	3.40	Rating **	A/W	Issue No.	3
LM End	3.54	Issue Type +	Ma	Location *	LS
Category	Earthen Levee			GPS Latitude/Longitude	
				Start	End
Item	Animal Control			37.253052 °	37.253600 °
				-120.722647 °	-120.720198 °
DWR ID	DWR_NA0010_08_s_2012_3				
Comment Code					
A3 : No rodents visible, but rodent burrows visible; need to backfill and compact or grout burrows.					
Inspector Comment					
Several rodent holes were noted on landside slope within this reach.

Looking at typical view of rodent holes on landward slope. (Spring 2022)

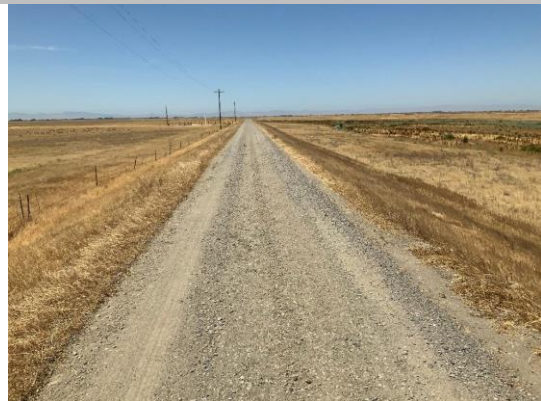
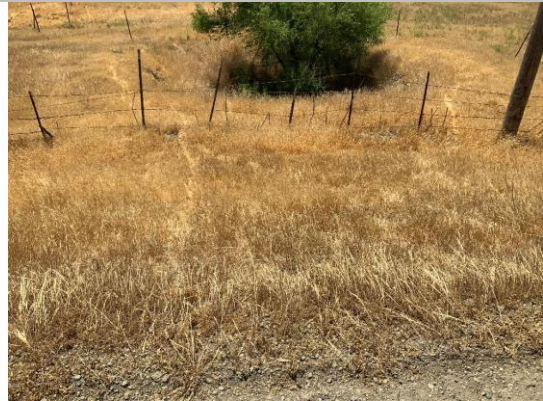
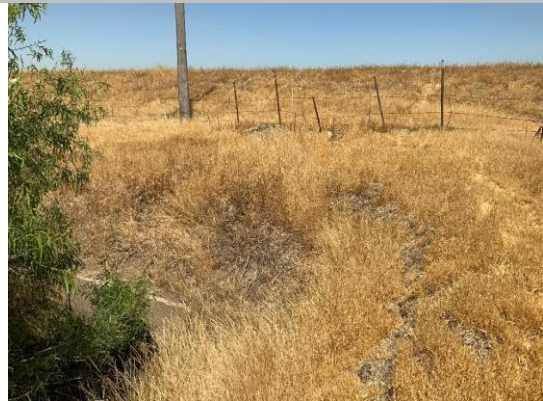
LM Start	3.43	Rating **	M	Issue No.	14
LM End	3.43	Issue Type +	Ma	Location *	
Category	Supplemental			GPS Latitude/Longitude	
				Start	End
Item	DWR UCIP LMA Responsibility			37.253151 °	37.253151 °
				-120.722182 °	-120.722182 °
DWR ID	19840

Comment Code					
Inspector Comment					
FS_ID:71188 DS_ID:19840 EP_NO: N/A Repair Type: Non-Urgent Crossing Status: Found UCIP Comments: 06/2/2021 Record remains Non-Urgent. LS pipe inlet blocked by barbed wire and both ends blocked by water, so limited inspection was done. No permit was found authorizing this encroachment. CVFPB will need to review crossing to determine owner. The UCIP inspection was completed with GEI staff, P. Espinoza. (H. Dunn ? GEI) 04/16/2014 No access available on landward side. Need to confirm status of crossing. (W. Wylie - DWR UCIP) FIELD_STRUCT_DESC: 24-inch corrugated metal gravity drainage pipe (CMP) through the levee, 13.0 feet below the crown. Flap gate on the waterside (WS) end. Concrete headwall on each end. [Additional Reference(s): DWR Levee Log, 2002, (HLM 3.43). USACE San Joaquin O&M Manual, Unit No. 601, Part No. 1, 1967, Amended in 1978, Revised 20 June 1985, (HLM 3.43). DWR As-Built Specification No. 63-25, Sheet No. 13, 9 May 1963, (HLM 3.43)]. FS Date: 6/2/2021

Levee crown looking downstream.

LS view: Toe from crown.

LS view: Slope from toe.

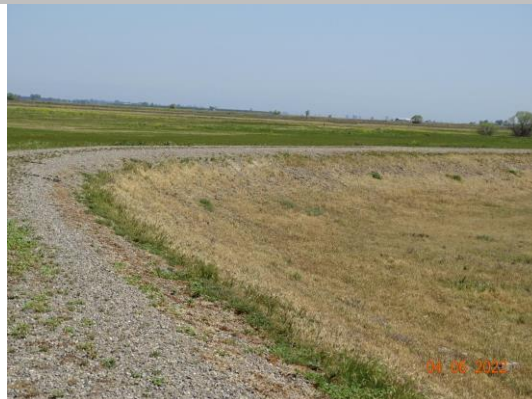
Photo 1 of 1 : SP_2022_NA0010_127_7_20220414_00013.jpg

LM Start	0.20	Rating **	A	Issue No.	7
LM End	0.20	Issue Type +	Ma	Location *	WS
Category	Earthen Levee			GPS Latitude/Longitude	
				Start	End
Item	Vegetation			37.219812 °	37.219812 °
				-120.709904 °	-120.709904 °
DWR ID	DWR_NA0010_09_s_2022_7				
Comment Code					
V1 : Control annual grass and weeds on the levee slopes and easements.					
Inspector Comment

View of vegetation management on the waterside slope. (Spring 2022)

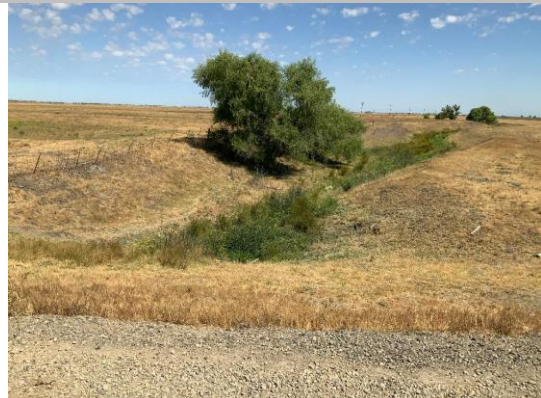
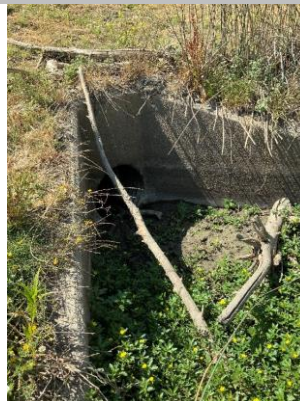
Comment Code					
Inspector Comment					
FS_ID:69554 DS_ID:19841 EP_NO: N/A Repair Type: Non-Urgent Crossing Status: Found UCIP Comments: 06/09/2021 The record remains Non-Urgent. Limited inspection of landside (LS) and WS due to water and mud. LS CMP riser has missing lid. WS outlet pipe edges are warped. No permit was found authorizing this encroachment. CVFPB will need to review crossing to determine owner. The UCIP inspection was completed with GEI staff, H.Dunn. (P.Espinoza ? GEI) 04/22/2014 Concrete headwalls on landward and waterward under water. Need photo to confirm condition of concrete headwalls, pipe, and gate on both toes. (W. Wylie - DWR UCIP) FIELD_STRUCT_DESC: 24-inch corrugated metal gravity drainage pipe through the levee, 18.7 feet below the crown. Slide gate in a 36-inch corrugated metal pipe (CMP) riser on the waterside (WS) slope. Concrete U-shaped headwall on each end. [Additional Reference(s): DWR Levee Log, 2002 (HLM 0.48), listed as a 24-inch corrugated metal pipe (CMP). USACE San Joaquin O&M Manual, Unit 601 Part 1 (SJR601.1), 1967, (HLM 0.47), listed as a 24-inch CMP]. FS Date: 6/9/2021 2:41:00 PM

Overview of levee from crown facing upstream. CMP riser visible on WS slope.

LS view: Toe from crown.

LS view: Concrete headwall and inlet pipe visible at toe.

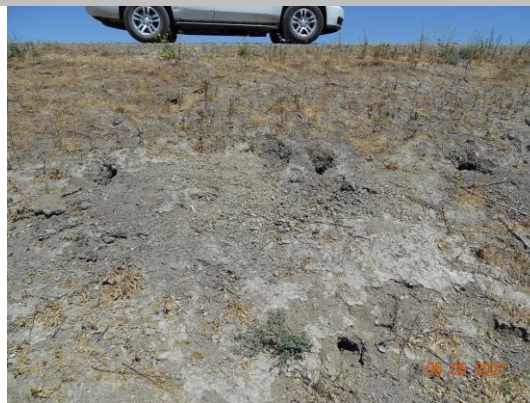
Photo 1 of 1 : SP_2022_NA0010_127_6_20220308_00003.jpg

LM Start	0.48	Rating **	M	Issue No.	6
LM End	0.48	Issue Type +	Ma	Location *	WS
Category	Earthen Levee			GPS Latitude/Longitude	
				Start	End
Item	Animal Control			37.220489 °	37.220489 °
				-120.705021 °	-120.705021 °
DWR ID	DWR_NA0010_09_s_2021_6				
Comment Code					
A1 : Exterminate rodents and backfill and compact or grout burrows.					
Inspector Comment

View of rodent burrows in the waterside slope. (Spring 2021)

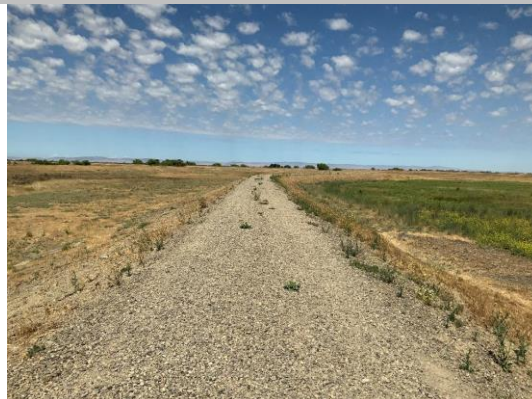
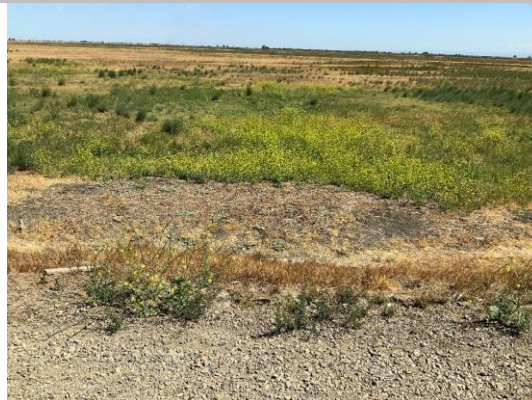
Comment Code					
Inspector Comment					
FS_ID:68984 DS_ID:19842 EP_NO: N/A Repair Type: Non-Urgent Crossing Status: Found UCIP Comments: 06/09/2021 The record remains Non-Urgent. DWR DMP internal inspection has not found pipe integrity issues. LOF of crossing is less or equal to 4.0. Recommend next video inspection in 5 years. No permit was found authorizing this encroachment. CVFPB will need to review crossing to determine owner. The UCIP inspection was completed with GEI staff, H.Dunn. (P.Espinoza ? GEI) 04/22/2014 Animal burrows in area on LS slope. Minor sediment buildup in pipe visible on landward side--recommend clearing. (W. Wylie - DWR UCIP) FIELD_STRUCT_DESC: 24-inch corrugated metal gravity drainage pipe through the levee, 8.7 feet below the crown. Flap gate on the waterside (WS) end. Concrete headwall on the landside (LS) end. Concrete U-shaped headwall on the WS end. [Additional Reference(s): DWR Levee Log, 2002 (HLM 0.70), listed as a 24-inch corrugated metal pipe (CMP). USACE San Joaquin O&M Manual, Unit 601 Part 1 (SJR601.1), 1967, (HLM 0.70), listed as a 24-inch CMP]. FS Date: 6/9/2021

View of levee crown.

LS view: Slope from crown.

LS view: Concrete headwall and inlet pipe at toe.

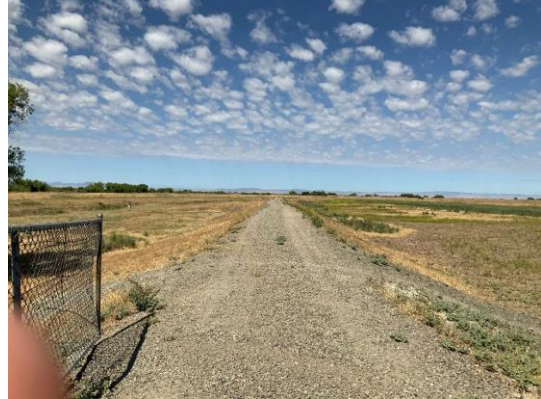
Photo 1 of 3 : UCIP_SP_2022_68989_103181.jpg

Comment Code						
Inspector Comment						
FS_ID:68989 DS_ID:19843 EP_NO: N/A Repair Type: Non-Urgent Crossing Status: Found UCIP Comments: 06/09/2021 The record has been upgraded from No Action Needed to Non-Urgent. No cover or handle on CMP riser on WS slope. Water in riser shows evidence that flapgate is open. Outlet pipe on WS toe not found. Dense vegetation and sediment limits inspectors ability to identify signs of inlet pipe condition on LS toe recommend removal of vegetation and sediment. LS inlet pipe appears to have slight warping around edges. No permit was found authorizing this encroachment. CVFPB will need to review crossing to determine owner. The UCIP inspection was completed with GEI staff, H.Dunn. (P.Espinoza ? GEI) FIELD_STRUCT_DESC: [Crane Irrigation Structure] 24-inch corrugated metal gravity drainage pipe through the levee, 9.7 feet below the crown. Two slide gates in a 48-inch corrugated metal pipe (CMP) riser on the waterside (WS) slope. Concrete U-shaped headwall on the landside (LS) end. WS end cobble revetted on the bank and in the outlet drain. [Additional Reference(s): DWR Levee Log, 2002 (HLM 0.87), listed as a 24-inch corrugated metal pipe (CMP). USACE San Joaquin O&M Manual, Unit 601 Part 1 (SJR601.1), 1967, (HLM 0.87), listed as a 24-inch CMP]. FS Date: 6/9/2021 4:30:00 PM

View of levee crown.

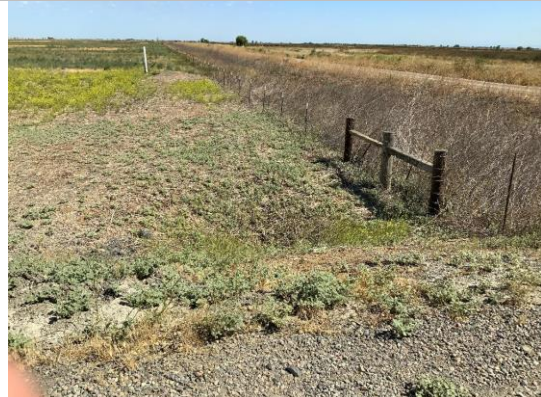
Photo 2 of 3 : UCIP_SP_2022_68989_103183.jpg

LS view: Toe from crown.

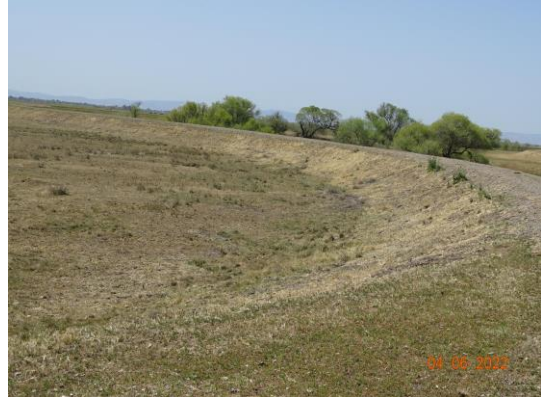
Photo 1 of 1 : SP_2022_NA0010_128_3_20220414_00005.jpg

LM Start	0.19	Rating **	A	Issue No.	3
LM End	0.19	Issue Type +	Ma	Location *	LS
Category	Earthen Levee			GPS Latitude/Longitude	
				Start	End
Item	Vegetation			37.219127 °	37.219127 °
				-120.708578 °	-120.708578 °
DWR ID	DWR_NA0010_10_s_2022_3				
Comment Code					
V1 : Control annual grass and weeds on the levee slopes and easements.					
Inspector Comment

View of vegetation management on the landside slope. (Spring 2022)

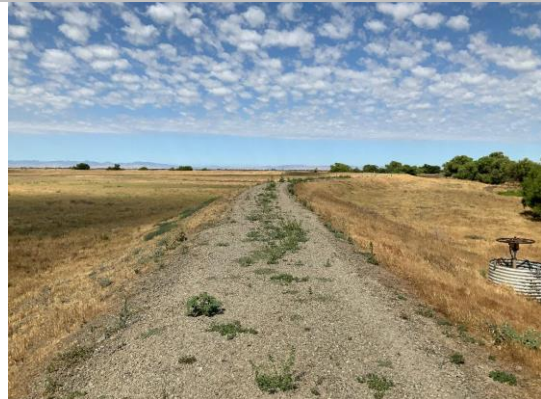
Photo 1 of 3 : UCIP_SP_2022_69817_103399.jpg

Comment Code						
Inspector Comment						
FS_ID:69817 DS_ID:19845 EP_NO: N/A Repair Type: Non-Urgent Crossing Status: Found UCIP Comments: 06/09/2021 The record remains Non-Urgent. No cover on CMP riser on WS slope, creating a safety hazard. Limited inspection of inlet pipe on LS and outlet pipe on WS due to elevated water levels around the headwalls and inlet/outlets, limiting the ability to inspect pipes at a close proximity. No permit was found authorizing this encroachment. CVFPB will need to review crossing to determine owner. The UCIP inspection was completed with GEI staff, H.Dunn. (P.Espinoza ? GEI) 04/22/2014 Inlet blocked at LS toe by wooden gate. Need to contact owner to determine status. (W. Wylie - DWR UCIP) FIELD_STRUCT_DESC: 36-inch corrugated metal gravity drainage pipe through the levee, 19.6 feet below the crown. Slide gate in a 48-inch corrugated metal pipe (CMP) riser on the waterside (WS) slope. Concrete U-shaped headwall on each end. [Additional Reference(s): DWR Levee Log, 2002 (HLM 0.31), listed as a 24-inch corrugated metal pipe (CMP). USACE San Joaquin O&M Manual, Unit 601 Part 1 (SJR601.1), 1967, (HLM 0.31), listed as a 24-inch CMP]. FS Date: 6/9/2021 11:34:00 AM

View of levee crown.

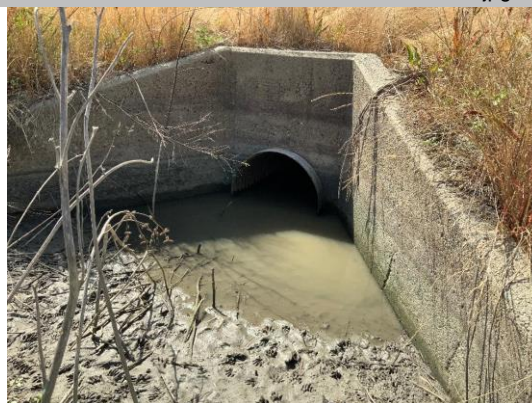
Photo 3 of 3 : UCIP_SP_2022_69817_103403.jpg

WS view: Concrete headwall and inlet pipe at toe.

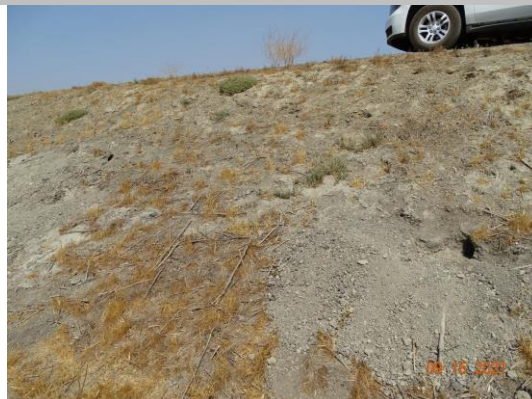
Photo 1 of 1 : SP_2022_NA0010_128_2_20220308_00001.jpg

LM Start	0.51	Rating **	M	Issue No.	2
LM End	0.51	Issue Type +	Ma	Location *	LS
Category	Earthen Levee			GPS Latitude/Longitude	
				Start	End
Item	Animal Control			37.219268 °	37.219268 °
				-120.703046 °	-120.703046 °
DWR ID	DWR_NA0010_10_f_2021_2				
Comment Code					
A3 : No rodents visible, but rodent burrows visible; need to backfill and compact or grout burrows.					
Inspector Comment

View squirrel holes on the landside slope. (Fall 2021)

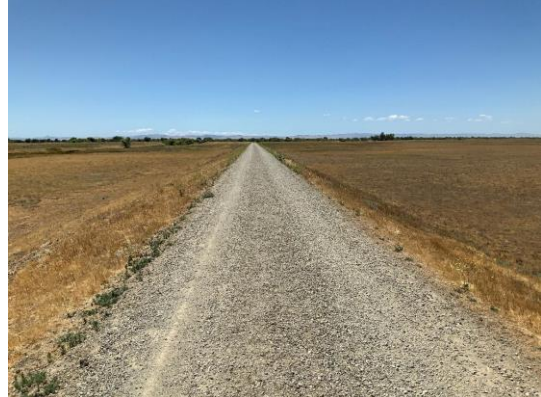
Photo 1 of 3 : UCIP_SP_2022_67619_100411.jpg

Comment Code						
Inspector Comment						
FS_ID:67619 DS_ID:19846 EP_NO: N/A Repair Type: Non-Urgent Crossing Status: Found UCIP Comments: 06/8/2021 The record remains Non-Urgent. WS pipe end either completely buried under dirt or has been removed. Only riser visible on WS slope, pipe end not visible at all. Recommend contacting owner to determine status of pipe. No permit was found authorizing this encroachment. CVFPB will need to review crossing to determine owner. The UCIP inspection was completed with GEI staff, P. Espinoza. (H. Dunn- GEI) 04/18/201 Need to contact owner. Recommend clearing sediment deposit inside pipe. (O. Magana - DWR UCIP) FIELD_STRUCT_DESC: 24-inch corrugated metal gravity drainage pipe through the levee, 11 feet below the crown. Slide gate in a corrugated metal pipe (CMP) riser on the waterside (WS) end. [Additional Reference(s): DWR Levee Log, 2002 (HLM 0.43), listed as a 24-inch corrugated metal pipe (CMP). USACE San Joaquin O&M Manual, Unit 601 Part 1 (SJR601.1), 1967, (HLM 0.42), listed as a 24-inch CMP]. FS Date: 6/8/2021

Levee crown looking downstream.

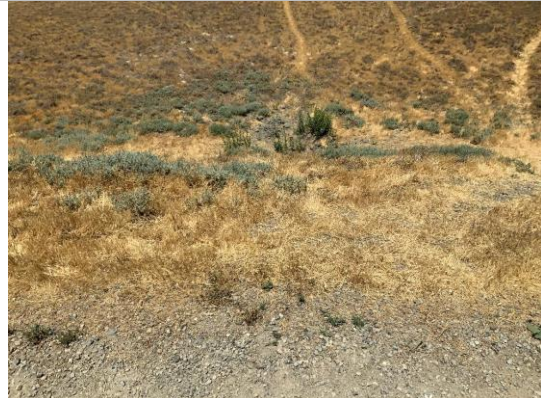
Photo 2 of 3 : UCIP_SP_2022_67619_100408.jpg

LS view: Toe from crown.

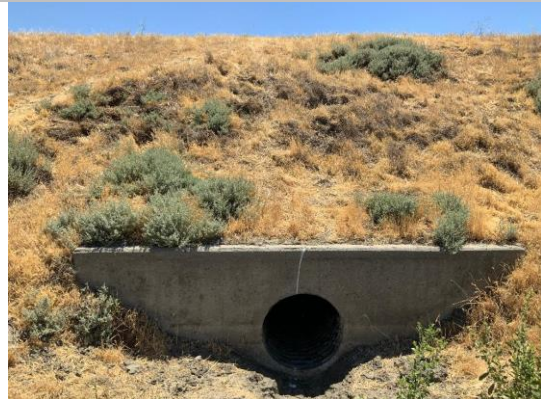
Photo 3 of 3 : UCIP_SP_2022_67619_100409.jpg

LS view: Slope and headwall at toe.

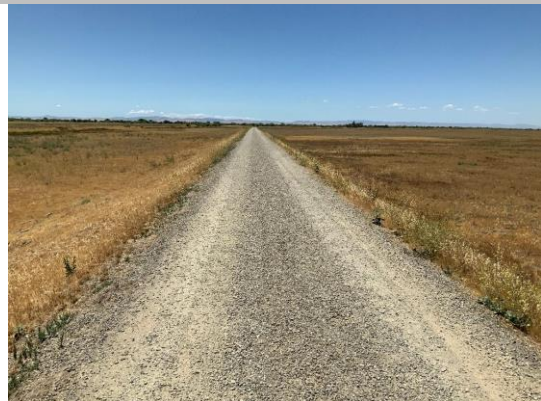
Photo 1 of 3 : UCIP_SP_2022_67927_100419.jpg

FS_ID:67927
DS_ID:19847
EP_NO: N/A
Repair Type: Non-Urgent
Crossing Status: Found
UCIP Comments: 06/8/2021 The record remains Non-Urgent. DWR DMP internal inspection has not found pipe integrity issues. LOF of crossing is less or equal to 4.0. Recommend next video inspection in 5 years. No permit was found authorizing this encroachment. CVFPB will need to review crossing to determine owner. The UCIP inspection was completed with GEI staff, P. Espinoza. (H. Dunn - GEI) 04/18/201
Need to contact owner. Recommend clearing sediment deposit inside pipe. (O. Magana - DWR UCIP)
FIELD_STRUCT_DESC: 24-inch corrugated metal gravity drainage pipe through the levee, 10 feet below the crown. Flap gate on the waterside (WS) end. [Additional Reference(s): DWR Levee Log, 2002 (HLM 0.65), listed as a 24-inch corrugated metal pipe (CMP). USACE San Joaquin O&M Manual, Unit 601 Part 1 (SJR601.1), 1967, (HLM 0.65), listed as a 24-inch CMP].

Levee crown looking downstream.

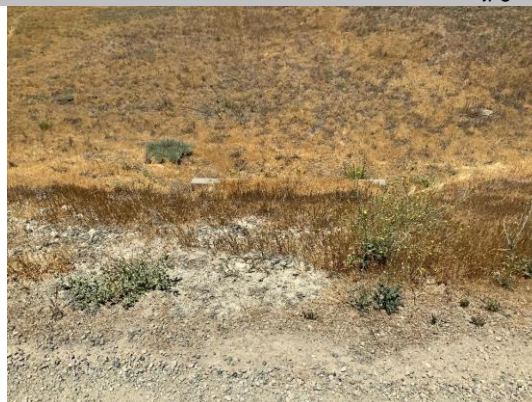
Photo 2 of 3 : UCIP_SP_2022_67621_100429.jpg

Comment Code						
Inspector Comment						
FS_ID:67621 DS_ID:19848 EP_NO: N/A Repair Type: Non-Urgent Crossing Status: Found UCIP Comments: 06/8/2021 The record remains Non-Urgent. DWR DMP internal inspection has not found pipe integrity issues. LOF of crossing is less or equal to 4.0. Recommend next video inspection in 5 years. No permit was found authorizing this encroachment. CVFPB will need to review crossing to determine owner. The UCIP inspection was completed with GEI staff, P. Espinoza. (H. Dunn - GEI) 04/18/201 Need to contact owner. Recommend clearing sediment deposit inside pipe. (O. Magana - DWR UCIP) FIELD_STRUCT_DESC: 24-inch corrugated metal gravity drainage pipe through the levee, 10.3 feet below the crown. Flap gate on the waterside (WS) end. [Additional Reference(s): DWR Levee Log, 2002 (HLM 0.85), listed as a 24-inch corrugated metal pipe (CMP). USACE San Joaquin O&M Manual, Unit 601 Part 1 (SJR601.1), 1967, (HLM 0.84), listed as a 24-inch CMP]. FS Date: 6/8/2021

LS view: Toe from crown.
