**Flood Control Project Maintenance
Levee Inspections
LMA District Cover Sheet**

Lower San Joaquin Levee District

**Flood Control Project Maintenance
Levee Inspections
Unit Cover Sheet**

Levee Inspection Report By Mile - Spring 2022

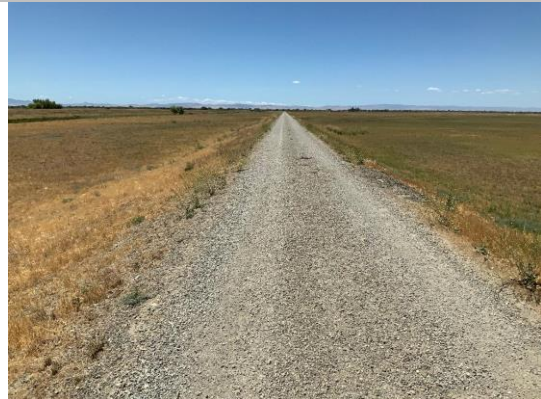
Photo 1 of 3 : UCIP_SP_2022_67622_100431.jpg

FS_ID:67622
DS_ID:19849
EP_NO: N/A
Repair Type: Non-Urgent
Crossing Status: Found
UCIP Comments: 06/8/2021 The record remains Non-Urgent. DWR DMP internal inspection has not found pipe integrity issues. LOF of crossing is less or equal to 4.0. Recommend next video inspection in 5 years. Dense tumbleweeds blocking both LS and WS ends, recommend removal. No permit was found authorizing this encroachment. CVFPB will need to review crossing to determine owner. The UCIP inspection was completed with GEI staff, P. Espinoza. (H. Dunn - GEI) 04/18/2014 Need to contact owner. Recommend clearing sediment deposit inside pipe. (O. Magana - DWR UCIP)
FIELD_STRUCT_DESC: 24-inch corrugated metal gravity drainage pipe through the levee, 9 feet below the crown. Flap gate on the waterside (WS) end. [Additional Reference(s): DWR Levee Log, 2002 (HLM 1.13), listed as a 24-inch corrugated metal pipe (CMP). USACE San Joaquin O&M Manual, Unit 601 Part 1 (SJR601.1), 1967, (HLM 1.13), listed as a 24-inch CMP].

Levee crown looking downstream.

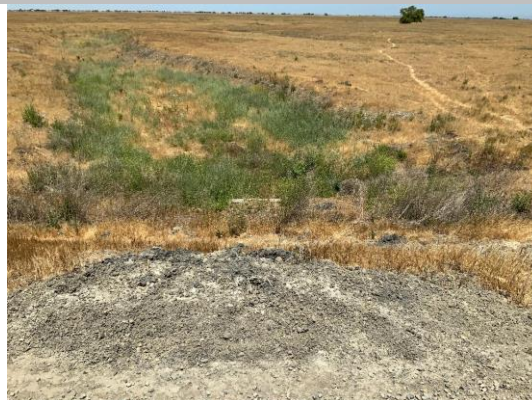
Photo 2 of 3 : UCIP_SP_2022_67623_100438.jpg

Comment Code						
Inspector Comment						
FS_ID:67623 DS_ID:19850 EP_NO: N/A Repair Type: Non-Urgent Crossing Status: Found UCIP Comments: 06/8/2021 The record remains Non-Urgent. Sediment buildup in both WS and LS pipe inlet and outlet, recommend clearing out. WS pipe edges are slightly warped. No permit was found authorizing this encroachment. CVFPB will need to review crossing to determine owner. The UCIP inspection was completed with GEI staff, P. Espinoza. (H. Dunn - GEI) 04/18/2014 Need to contact owner. Recommend clearing sediment deposit inside pipe. (O. Magana - DWR UCIP) FIELD_STRUCT_DESC: 48-inch corrugated metal gravity drainage pipe through the levee, 16.3 feet below the crown. Slide gate in a pipe riser on the waterside (WS) slope. [Additional Reference(s): DWR Levee Log, 2002 (HLM 1.50), listed as a 48-inch corrugated metal pipe (CMP). USACE San Joaquin O&M Manual, Unit 601 Part 1 (SJR601.1), 1967, (HLM 1.50), listed as a 48-inch CMP]. FS Date: 6/8/2021

LS view: Headwall visible at toe from crown.

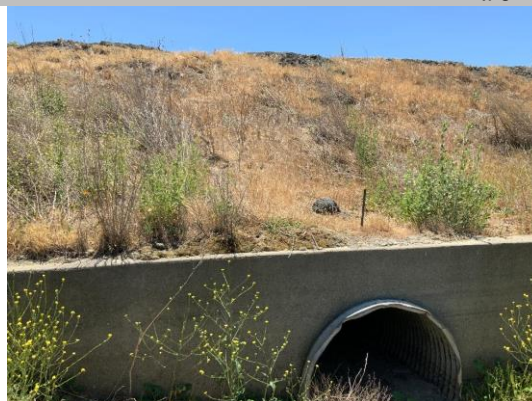
Photo 3 of 3 : UCIP_SP_2022_67623_100439.jpg

LS view: Slope and headwall from toe.

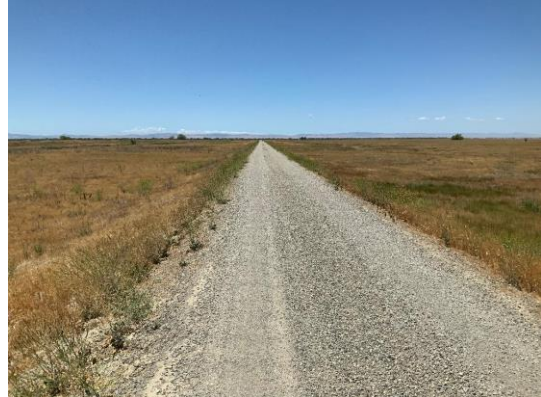
Photo 1 of 3 : UCIP_SP_2022_67624_100447.jpg

Comment Code					
Inspector Comment					
FS_ID:67624 DS_ID:19851 EP_NO: N/A Repair Type: Non-Urgent Crossing Status: Found UCIP Comments: 06/8/2021 The record remains Non-Urgent. DWR DMP internal inspection has found pipe integrity issues. LOF of crossing is between 4.1 and 5. Crossing will be monitored until funding becomes available for rehabilitation. Vegetation on both WS and LS ends, recommend removal. No permit was found authorizing this encroachment. CVFPB will need to review crossing to determine owner. The UCIP inspection was completed with GEI staff, P. Espinoza. (H. Dunn - GEI) 04/18/201 Need to contact owner. Recommend clearing sediment deposit inside pipe. (O. Magana - DWR UCIP) FIELD_STRUCT_DESC: 24-inch corrugated metal gravity drainage pipe through the levee, 12.8 feet below the crown. Flap gate on the waterside (WS) end. [Additional Reference(s): DWR Levee Log, 2002 (HLM 1.99), listed as a 24-inch corrugated metal pipe (CMP). USACE San Joaquin O&M Manual, Unit 601 Part 1 (SJR601.1), 1967, (HLM 1.99), listed as a 24-inch CMP]. FS Date: 6/8/2021

Levee crown looking downstream.

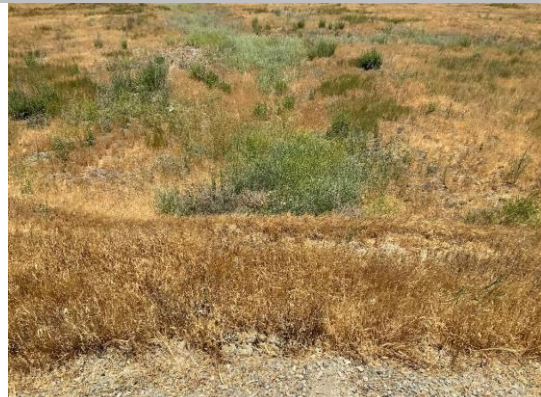
Photo 2 of 3 : UCIP_SP_2022_67624_100444.jpg

LS view: Toe from crown.

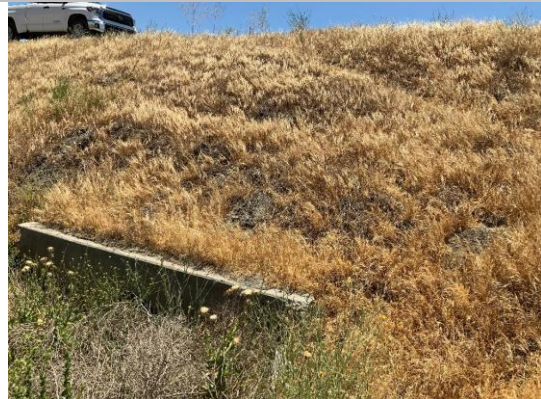
Photo 3 of 3 : UCIP_SP_2022_67624_100445.jpg

LS view: Headwall and slope from toe.

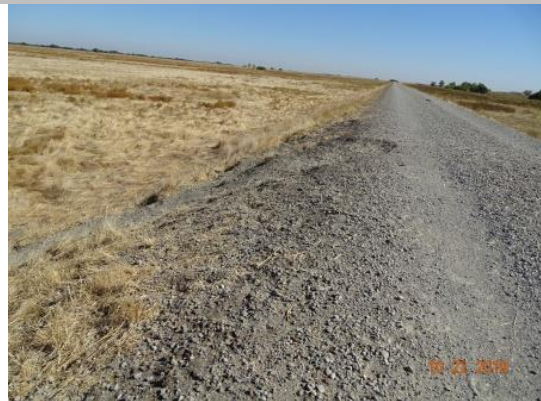
Photo 1 of 1 : SP_2022_NA0010_129_17_20220308_00007.jpg

LM Start	2.31	Rating **	M	Issue No.	17
LM End	2.31	Issue Type +	Ma	Location *	LS
Category	Earthen Levee			GPS Latitude/Longitude	
				Start	End
Item	Erosion / Livestock			37.202730 °	37.202730 °
				-120.713368 °	-120.713368 °
DWR ID	DWR_NA0010_11_f_2019_17				
Comment Code					
E4 : Repair the levee slope damaged by livestock and prevent large animal access.					
Inspector Comment

Damage to the landside slope from livestock traffic. (Fall 2019)

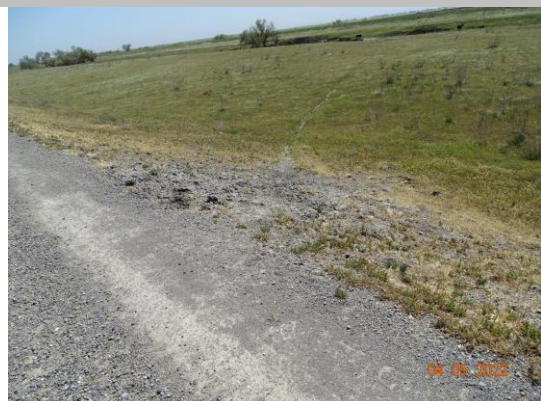
Photo 1 of 2 : SP_2022_NA0010_129_12_20220414_00037.jpg

LM Start	2.46	Rating **	A/W	Issue No.	12
LM End	2.46	Issue Type +	Ma	Location *	LS
Category	Earthen Levee			GPS Latitude/Longitude	
				Start	End
Item	Erosion / Livestock			37.202712 °	37.202712 °
				-120.710633 °	-120.710633 °
DWR ID	DWR_NA0010_11_f _ 2018_12				
Comment Code					
E4 : Repair the levee slope damaged by livestock and prevent large animal access.					
Inspector Comment					
Damage is from livestock to both landside and waterside slopes.

View of the landside slope. (Spring 2022)

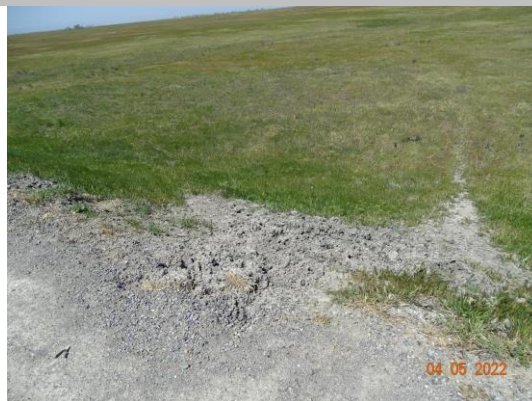
Photo 2 of 2 : SP_2022_NA0010_129_12_20220414_00038.jpg

View of the waterside slope. (Spring 2022)

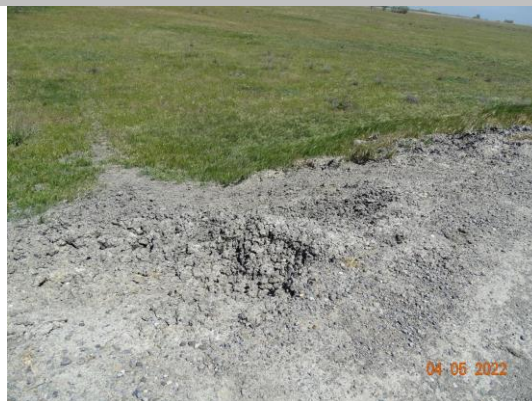
Photo 1 of 1 : SP_2022_NA0010_129_16_20220414_00039.jpg

LM Start	2.52	Rating **	A/W	Issue No.	16
LM End	2.52	Issue Type +	Ma	Location *	LS
Category	Earthen Levee			GPS Latitude/Longitude	
				Start	End
Item	Erosion / Livestock			37.202738 °	37.202738 °
				-120.709455 °	-120.709455 °
DWR ID	DWR_NA0010_11_s_2022_16				
Comment Code					
E4 : Repair the levee slope damaged by livestock and prevent large animal access.					
Inspector Comment

Looking downhill and damage to the landside slope. (Spring 2022)

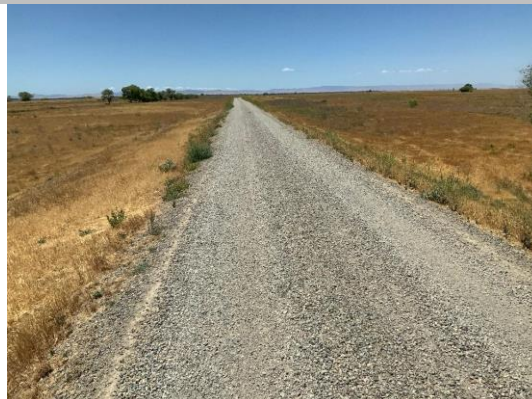
Photo 1 of 3 : UCIP_SP_2022_67928_100453.jpg

Comment Code					
Inspector Comment					
FS_ID:67928 DS_ID:19852 EP_NO: N/A Repair Type: Urgent Crossing Status: Found UCIP Comments: 06/8/2021 The record has been upgraded from Non-Urgent to Urgent. DWR DMP internal inspection has found pipe integrity issues. LOF of crossing is between 5 and 6. Crossing will be monitored until funding becomes available to address the issues. No permit was found authorizing this encroachment. CVFPB will need to review crossing to determine owner. Pipe has since been cleared out of sediment since previous inspection. The UCIP inspection was completed with GEI staff, P. Espinoza. (H. Dunn- GE)04/18/201 Need to contact owner. Recommend clearing sediment deposit inside pipe. (O. Magana - DWR UCIP) FIELD_STRUCT_DESC: 24-inch corrugated metal gravity drainage pipe through the levee, 15 feet below the crown. Flap gate on the waterside (WS) end. [Additional Reference(s): DWR Levee Log, 2002 (HLM 3.04), listed as a 24-inch corrugated metal pipe (CMP). USACE San Joaquin O&M Manual, Unit 601 Part 1 (SJR601.1), 1967, (HLM 3.04), listed as a 24-inch CMP]. FS Date: 6/8/2021

Levee crown looking downstream.

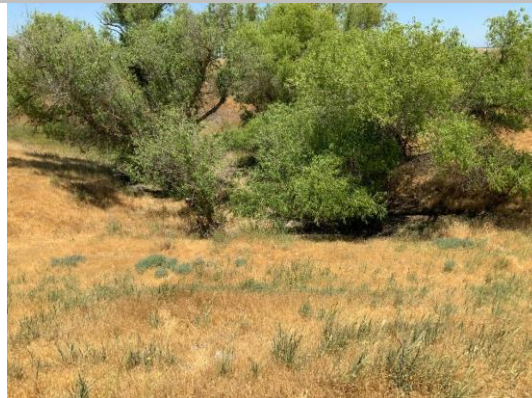
Photo 2 of 3 : UCIP_SP_2022_67928_100457.jpg

LS view: Toe from crown.

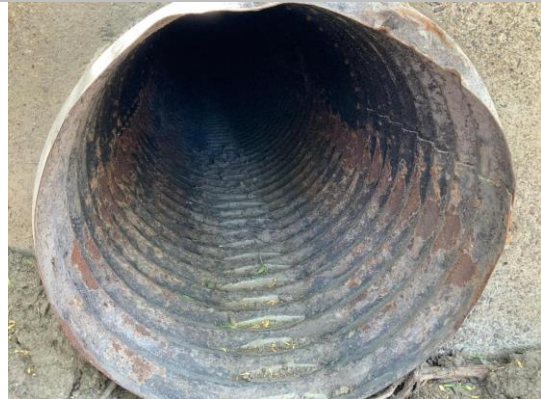
Photo 3 of 3 : UCIP_SP_2022_67928_100451.jpg

LS view: Close up of pipe inlet at toe.

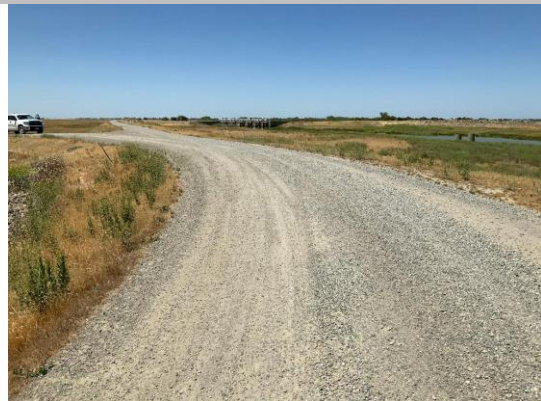
Photo 1 of 3 : UCIP_SP_2022_67929_100458.jpg

FS_ID:67929
DS_ID:25542
EP_NO: N/A
Repair Type: Non-Urgent
Crossing Status: Not Found
UCIP Comments: 06/8/2021 The record is Non-Urgent. Pipe not found by visual inspection. This appears to potentially be inside a different unit based on the CLM since this unit only goes from CLM 0 to 3.31. Either way, it was not observed in the field. Recommend contacting owner to determine status of pipe. No permit was found authorizing this encroachment. CVFPB will need to review crossing to determine owner. The UCIP inspection was completed with GEI staff, P. Espinoza. (H. Dunn- GEI)09/23/202 UCIP record brought online. Confirm location. (O. Magana - DWR UCIP)
FIELD_STRUCT_DESC: 24-inch corrugated metal drainage pipe through the levee, 15.0 feet below the crown. Flap gate on the waterside (WS) end. [Additional Reference(s): DWR Levee Log, 2002 (HLM 3.32), listed as a 24-inch corrugated metal pipe (CMP). USACE San Joaquin O&M Manual, Unit 601 Part 1 (SJR601.1), 1967, (HLM 3.32), listed as a 24-inch CMP].

Levee crown on adjacent unit bisecting this one.

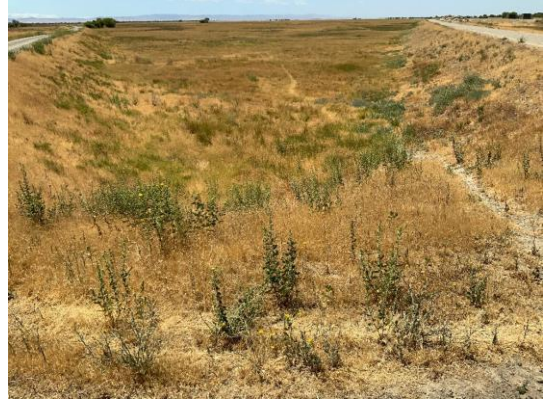
Photo 2 of 3 : UCIP_SP_2022_67929_100460.jpg

LS view: Slope from toe, no pipe visible.

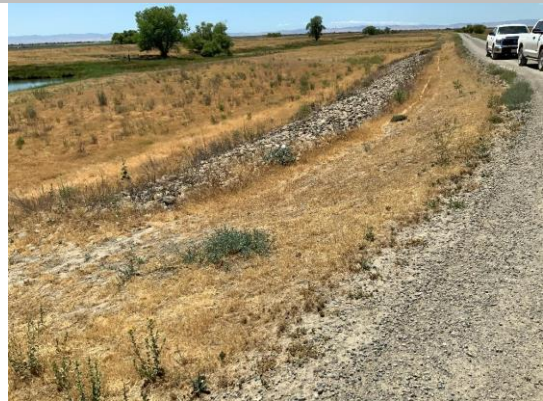
Photo 3 of 3 : UCIP_SP_2022_67929_100459.jpg

WS view: Slope from toe, no pipe visible.

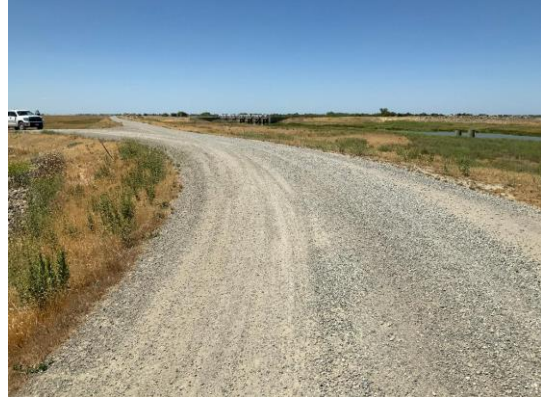
Photo 1 of 3 : UCIP_SP_2022_67931_100461.jpg

Comment Code					
Inspector Comment					
FS_ID:67931 DS_ID:25543 EP_NO: N/A Repair Type: Non-Urgent Crossing Status: Not Found UCIP Comments: 06/06/2021 The record is Non-Urgent. Pipe not found by visual inspection. This appears to potentially be inside a different unit based on the CLM since this unit only goes from CLM 0 to 3.31. Either way, it was not observed in the field. Recommend contacting owner to determine status of pipe. No permit was found authorizing this encroachment. CVFPB will need to review crossing to determine owner. The UCIP inspection was completed with GEI staff, P. Espinoza. (H. Dunn ? GEI)09/23/2020 UCIP record brought online. Confirm location. (O. Magana - DWR UCIP) FIELD_STRUCT_DESC: [Eastside Canal Siphon] 48-inch corrugated metal pipe through the levee, 16.0 feet below the crown and under channel. Slide gate on landside (LS) end. [Additional Reference(s): DWR Levee Log, 2002 (HLM 3.33), listed as a 48-inch corrugated metal pipe (CMP). USACE San Joaquin O&M Manual, Unit 601 Part 1 (SJR601.1), 1967, (HLM 3.33), listed as a 48-inch CMP]. FS Date: 6/8/2021

Levee crown of bisecting unit section.

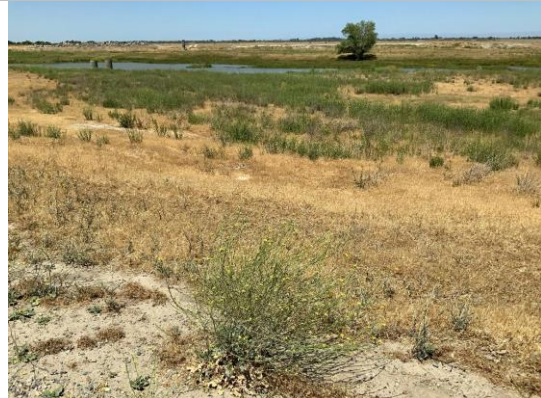
Photo 2 of 3 : UCIP_SP_2022_67931_100463.jpg

LS view: Slope from crown, no pipe visible.

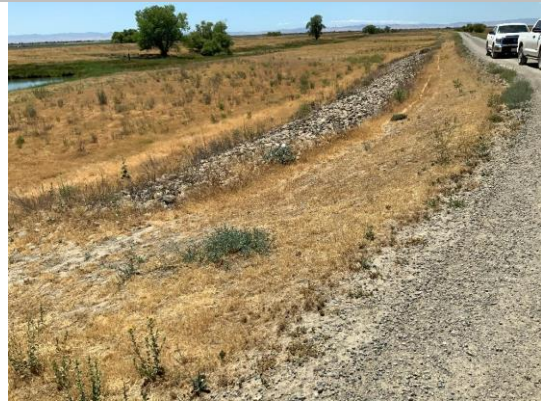
Photo 3 of 3 : UCIP_SP_2022_67931_100464.jpg

WS view: Slope from crown, no pipe visible.

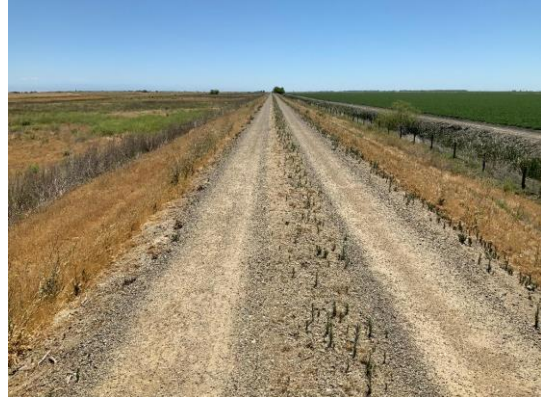
Photo 1 of 3 : UCIP_SP_2022_67726_100627.jpg

Comment Code						
Inspector Comment						
FS_ID:67726 DS_ID:19855 EP_NO: N/A Repair Type: Non-Urgent Crossing Status: Found UCIP Comments: 06/8/2021 The record remains Non-Urgent. DWR DMP internal inspection has not found pipe integrity issues. LOF of crossing is less or equal to 4.0. Recommend next video inspection in 5 years. No permit was found authorizing this encroachment. CVFPB will need to review crossing to determine owner. The UCIP inspection was completed with GEI staff, P. Espinoza. (H. Dunn ? GEI) 04/18/2014 Need to contact owner. Dense vegetation limits the inspector's visibility to identify signs of pipe failure (leaks) along the waterward slope. Recommend removing vegetation along pipe alignment to conduct proper inspection of structure. (O. Magana - DWR UCIP) FIELD_STRUCT_DESC: 24-inch corrugated metal gravity drainage pipe through the levee, 10.5 feet below the crown. Flap gate on the waterside (WS) end. [Additional Reference(s): DWR Levee Log, 2002 (HLM 0.41), listed as a 24-inch corrugated metal pipe (CMP). USACE San Joaquin O&M Manual, Unit 601 Part 1 (SJR601.1), 1967, (HLM 0.39), listed as a 24-inch CMP]. FS Date: 6/8/2021

Levee crown looking downstream.

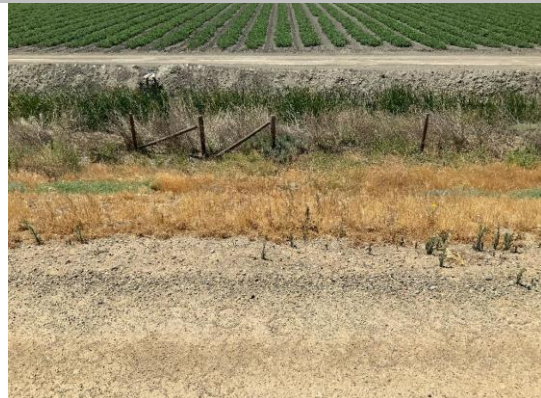
Photo 2 of 3 : UCIP_SP_2022_67726_100630.jpg

LS view: Toe from crown.

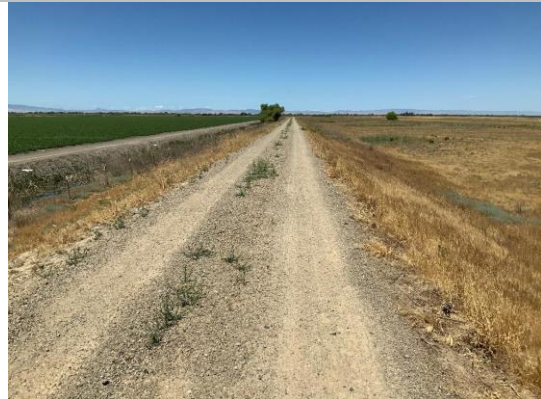
Photo 1 of 3 : UCIP_SP_2022_68233_100633.jpg

FS_ID:68233
DS_ID:19856
EP_NO: N/A
Repair Type: Non-Urgent
Crossing Status: Found
UCIP Comments: 06/8/2021 The record remains Non-Urgent. DWR DMP internal inspection has not found pipe integrity issues. LOF of crossing is less or equal to 4.0. Recommend next video inspection in 5 years. Some vegetation growth starting over WS flapgate and LS pipe inlet, recommend removal. No permit was found authorizing this encroachment. CVFPB will need to review crossing to determine owner. The UCIP inspection was completed with GEI staff, P. Espinoza. (H. Dunn ? GEI) 04/18/2014 Need to contact owner. Recommend clearing sediment deposit inside pipe. (O. Magana - DWR UCIP)
FIELD_STRUCT_DESC: 24-inch corrugated metal gravity drainage pipe through the levee, 10.5 feet below the crown. Flap gate on the waterside (WS) end. [Additional Reference(s): DWR Levee Log, 2002 (HLM 1.06), listed as a 24-inch corrugated metal pipe (CMP). USACE San Joaquin O&M Manual, Unit 601 Part 1 (SJR601.1), 1967, (HLM 1.06), listed as a 24-inch CMP].

Levee crown looking upstream.

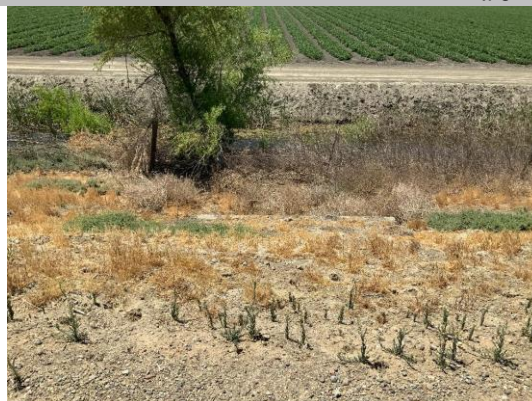
Photo 2 of 3 : UCIP_SP_2022_68233_100637.jpg

LS view: Headwall visible at toe from crown.

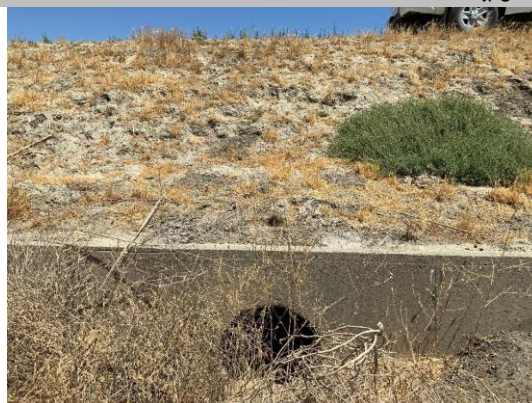
Photo 3 of 3 : UCIP_SP_2022_68233_100631.jpg

LS view: Slope and headwall at toe.

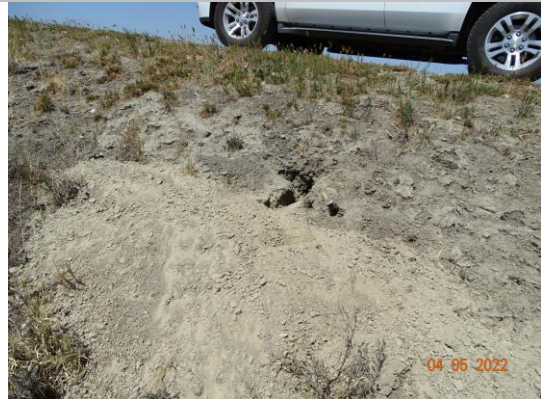
Photo 1 of 1 : SP_2022_NA0010_130_10_20220414_00025.jpg

LM Start	1.15	Rating **	M	Issue No.	10
LM End	1.15	Issue Type +	Ma	Location *	LS
Category	Earthen Levee			GPS Latitude/Longitude	
				Start	End
Item	Animal Control			37.200935 °	37.200935 °
				-120.734471 °	-120.734471 °
DWR ID	DWR_NA0010_12_s_2022_10				
Comment Code					
A3 : No rodents visible, but rodent burrows visible; need to backfill and compact or grout burrows.					
Inspector Comment

View of rodent hole with a large quantity of material removed. (Spring 2022)

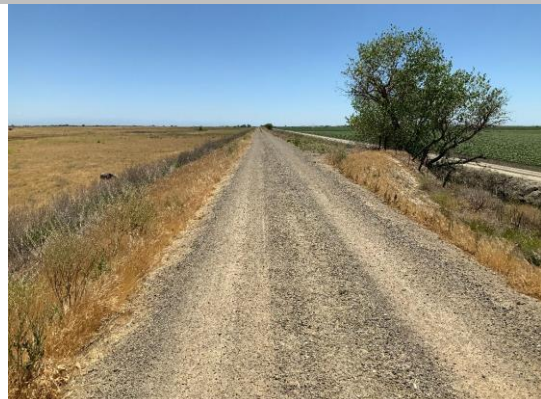
Photo 1 of 3 : UCIP_SP_2022_67728_100640.jpg

Comment Code						
Inspector Comment						
FS_ID:67728 DS_ID:19857 EP_NO: N/A Repair Type: Non-Urgent Crossing Status: Not Found UCIP Comments: 06/8/2021 The record remains Non-Urgent. Pipe not found during visual inspection due to dense vegetation on both WS and LS ends. LS end was also blocked off by barbed wire which limited inspection. Recommend removing vegetation in order to assess condition of pipe. No permit was found authorizing this encroachment. CVFPB will need to review crossing to determine owner. The UCIP inspection was completed with GEI staff, P. Espinoza. (H. Dunn ? GEI) 04/18/2014 Landward side not accessible due to dense vegetation and fence. Concrete headwall and flap gate under water therefore not able to evaluate condition. Will need to coordinate with owner to evaluate condition of crossing on waterward side and obtain access to evaluate landward side. (O. Magana - DWR UCIP) FIELD_STRUCT_DESC: 24-inch corrugated metal gravity drainage pipe through the levee, 17.4 feet below the crown. Flap gate on the waterside (WS) end. [Additional Reference(s): DWR Levee Log, 2002 (HLM 1.28), listed as a 24-inch corrugated metal pipe (CMP). USACE San Joaquin O&M Manual, Unit 601 Part 1 (SJR601.1), 1967, (HLM 1.27), listed as a 24-inch CMP]. FS Date: 6/8/2021

Levee crown looking downstream.

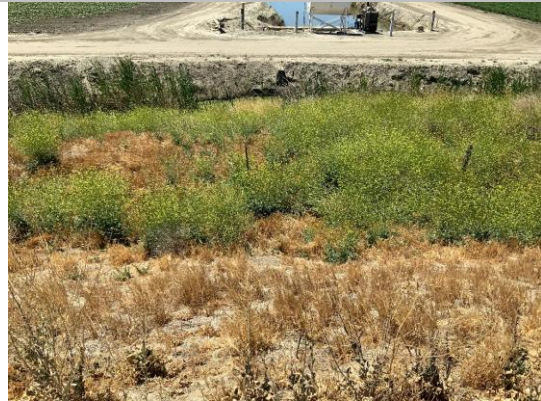
Photo 2 of 3 : UCIP_SP_2022_67728_100644.jpg

LS view: Toe from crown.

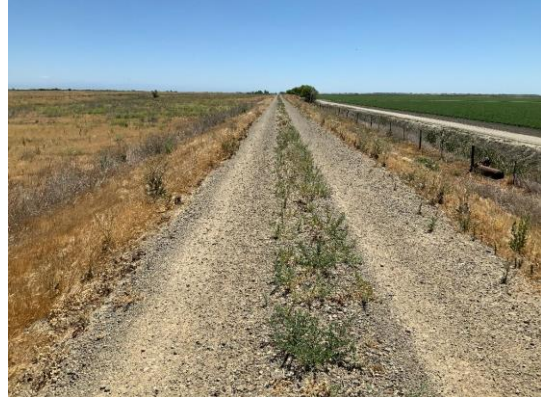
Photo 1 of 3 : UCIP_SP_2022_67729_100646.jpg

Comment Code						
Inspector Comment						
FS_ID:67729 DS_ID:19858 EP_NO: N/A Repair Type: Non-Urgent Crossing Status: Found UCIP Comments: 06/8/2021 The record remains Non-Urgent. DWR DMP internal inspection has not found pipe integrity issues. LOF of crossing is less or equal to 4.0. Recommend next video inspection in 5 years. Dense vegetation over LS pipe inlet, headwall barely visible. Recommend removal of vegetation. No permit was found authorizing this encroachment. CVFPB will need to review crossing to determine owner. The UCIP inspection was completed with GEI staff, P. Espinoza. (H. Dunn ? GEI) 04/18/2014 Limited access on landward side due to fence and dense vegetation. Recommend obtaining access to landward side and clear vegetation on landward side. (O. Magana - DWR UCIP) FIELD_STRUCT_DESC: 24-inch corrugated metal gravity drainage pipe through the levee, 10.7 feet below the crown. Flap gate on the waterside (WS) end. [Additional Reference(s): DWR Levee Log, 2002 (HLM 1.53), listed as a 24-inch corrugated metal pipe (CMP). USACE San Joaquin O&M Manual, Unit 601 Part 1 (SJR601.1), 1967, (HLM 1.53), listed as a 24-inch CMP]. FS Date: 6/8/2021

Levee crown looking upstream.

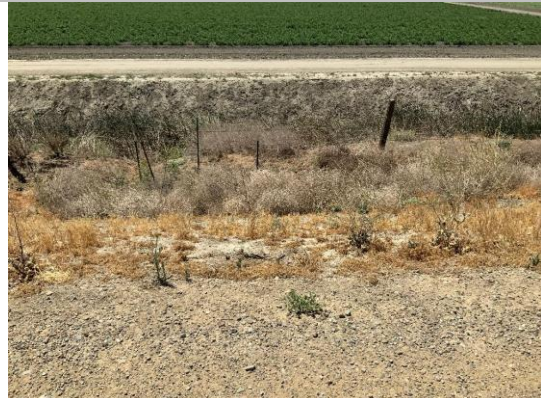
Photo 2 of 3 : UCIP_SP_2022_67729_100650.jpg

LS view: Toe from crown.

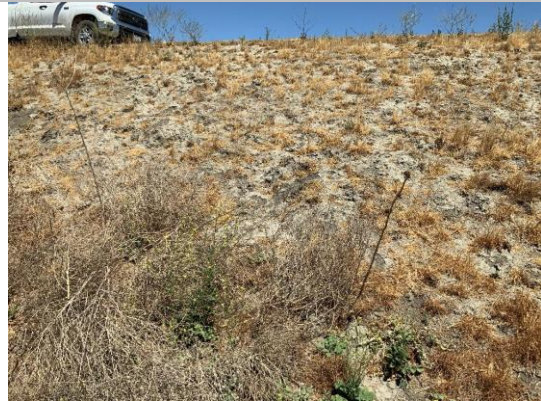
Photo 3 of 3 : UCIP_SP_2022_67729_100651.jpg

LS view: Slope from toe.

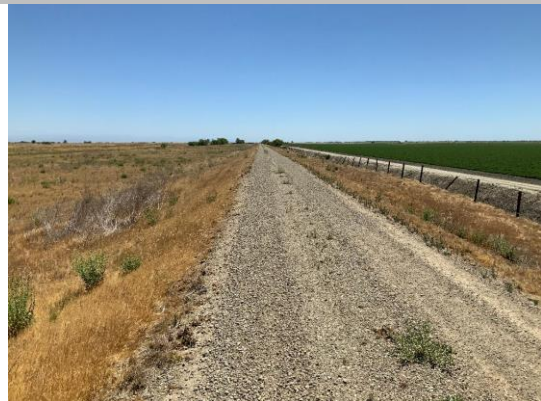
Photo 1 of 3 : UCIP_SP_2022_68234_100655.jpg

FS_ID:68234
DS_ID:19859
EP_NO: N/A
Repair Type: Non-Urgent
Crossing Status: Found
UCIP Comments: 06/8/2021 The record remains Non-Urgent. DWR DMP internal inspection has not found pipe integrity issues. LOF of crossing is less or equal to 4.0. Recommend next video inspection in 5 years. LS pipe inlet inaccessible due to barbed wire, just the top of the headwall visible. No permit was found authorizing this encroachment. CVFPB will need to review crossing to determine owner. The UCIP inspection was completed with GEI staff, P. Espinoza. (H. Dunn ? GEI)

Levee crown looking upstream.

04/18/2014 Need to contact owner. Recommend clearing vegetation from landward side--headwall blocked. (O. Magana - DWR UCIP)
FIELD_STRUCT_DESC: 24-inch corrugated metal gravity drainage pipe through the levee, 14.4 feet below the crown. Flap gate on the waterside (WS) end. [Additional Reference(s): DWR Levee Log, 2002 (HLM 2.16), listed as a 24-inch corrugated metal pipe (CMP). USACE San Joaquin O&M Manual, Unit 601 Part 1 (SJR601.1), 1967, (HLM 2.16), listed as a 24-inch CMP].
FS Date: 6/8/2021

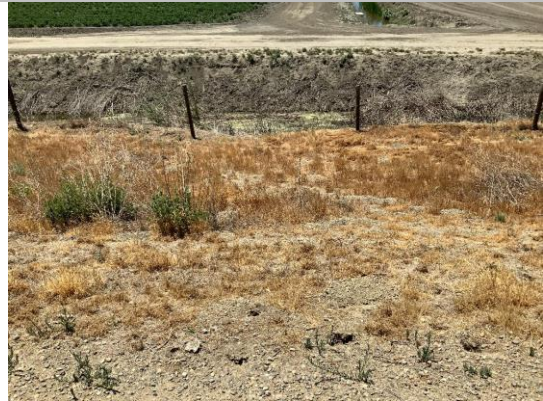
Photo 2 of 3 : UCIP_SP_2022_68234_100659.jpg

LS view: Toe from crown.

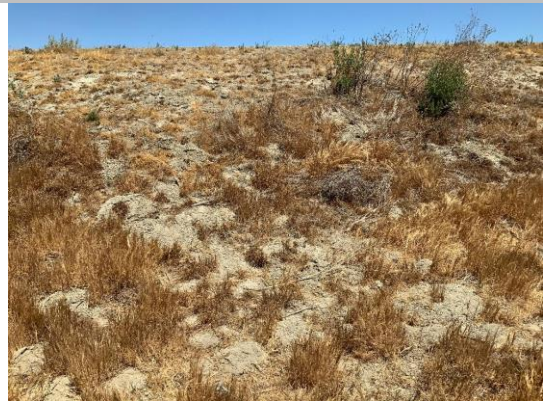
Photo 3 of 3 : UCIP_SP_2022_68234_100653.jpg

LM Start	2.16	Rating **	M	Issue No.	5 (cont)
LM End	2.16	Issue Type +	Ma	Location *

LS view: Slope from toe.

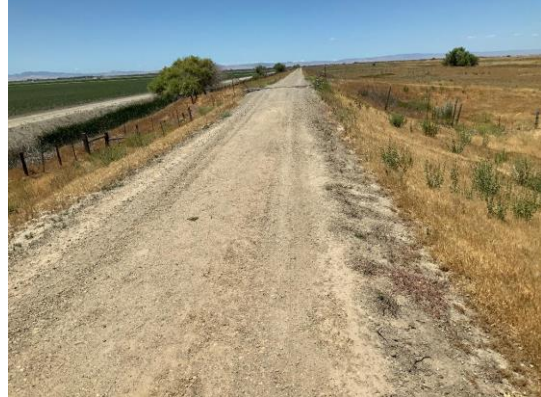
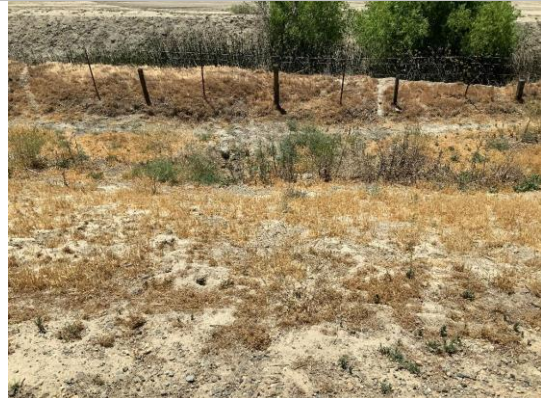
Comment Code						
Inspector Comment						
FS_ID:67731 DS_ID:19860 EP_NO: N/A Repair Type: Non-Urgent Crossing Status: Found UCIP Comments: 06/8/2021 The record remains Non-Urgent. DWR DMP internal inspection has not found pipe integrity issues. LOF of crossing is less or equal to 4.0. Recommend next video inspection in 5 years. LS pipe inlet covered with vegetation, recommend removal. No permit was found authorizing this encroachment. CVFPB will need to review crossing to determine owner. The UCIP inspection was completed with GEI staff, P. Espinoza. (H. Dunn ? GEI) 04/18/2014 Need to contact owner. Recommend clearing sediment deposit inside pipe. (O. Magana - DWR UCIP) FIELD_STRUCT_DESC: 24-inch corrugated metal gravity drainage pipe through the levee, 10.7 feet below the crown. Flap gate on the waterside (WS) end. [Additional Reference(s): DWR Levee Log, 2002 (HLM 2.70), listed as a 24-inch corrugated metal pipe (CMP). USACE San Joaquin O&M Manual, Unit 601 Part 1 (SJR601.1), 1967, (HLM 2.70), listed as a 24-inch CMP]. FS Date: 6/8/2021

LM Start	2.70	Rating **	M	Issue No.	6 (cont)
LM End	2.70	Issue Type +	Ma	Location *	
Category	Supplemental			GPS Latitude/Longitude	
				Start	End
Item	DWR UCIP LMA Responsibility			37.200906 °	37.200906 °
				-120.706316 °	-120.706316 °
DWR ID	19860

LS view: Headwall and slope from toe.

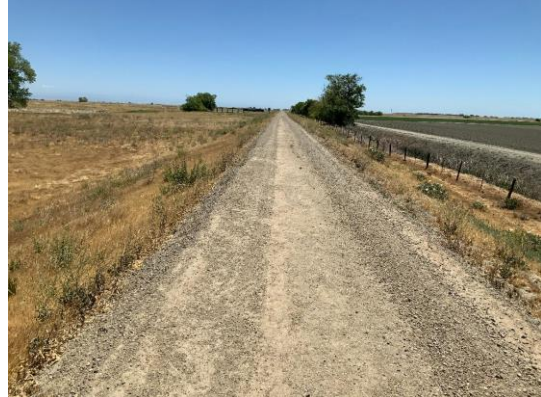
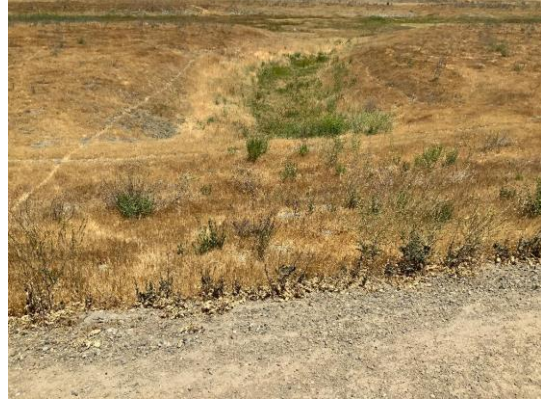
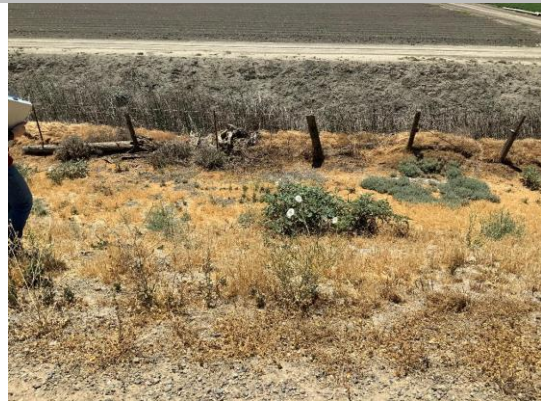
Comment Code						
Inspector Comment						
FS_ID:68235 DS_ID:19861 EP_NO: N/A Repair Type: Non-Urgent Crossing Status: Found UCIP Comments: 06/8/2021 The record remains Non-Urgent. DWR DMP internal inspection has not found pipe integrity issues. LOF of crossing is less or equal to 4.0. Recommend next video inspection in 5 years. LS pipe inlet inaccessible due to barbed wire and WS flapgate surrounded by water, limited inspection for both. LS pipe inlet also has dense vegetation covering it, recommend removal. No permit was found authorizing this encroachment. CVFPB will need to review crossing to determine owner. The UCIP inspection was completed with GEI staff, P. Espinoza. (H. Dunn ? GEI) 11/09/2015 DWR Inspection section confirmed issue has been addressed. Need to coordinate with LMA to determine additional details for extent of repair. (O. Magana - DWR UCIP)04/18/2014 Soil missing behind concrete headwall on waterward side. Unable to determine if missing soil is due to sink holes, rodent activity, or due to erosion. Headwall appears to be leaning slightly forward. Reason why this crossing was labelled urgent was due to the uncertainty of damage to concrete headwall and reason for soil missing behind concrete. Need to coordinate with LMA to determine more information about repair at this location. (O. Magana -DWR UCIP) FIELD_STRUCT_DESC: 24-inch corrugated metal gravity drainage pipe through the levee, 2 feet below the crown. Flap gate on the waterside (WS) end. [Additional Reference(s): DWR Levee Log, 2002 (HLM 3.00), listed as a 24-inch corrugated metal pipe (CMP). USACE San Joaquin O&M Manual, Unit 601 Part 1 (SJR601.1), 1967, (HLM 3.00), listed as a 24-inch CMP]. FS Date: 6/8/2021

LM Start	3.00	Rating **	M	Issue No.	7 (cont)	
LM End	3.00	Issue Type +	Ma	Location *		
Category	Supplemental			GPS Latitude/Longitude		
				Start		End
Item	DWR UCIP LMA Responsibility			37.200931 °	37.200931 °	
				-120.700908 °	-120.700908 °	
DWR ID	19861

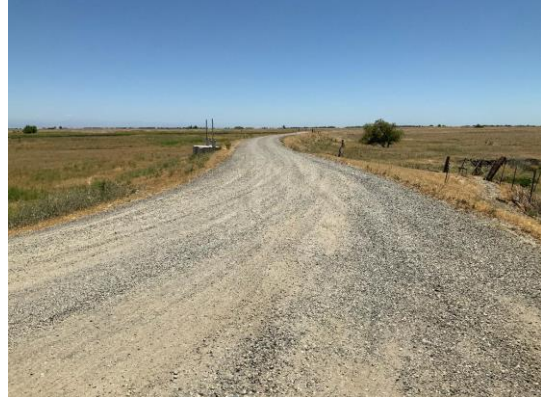
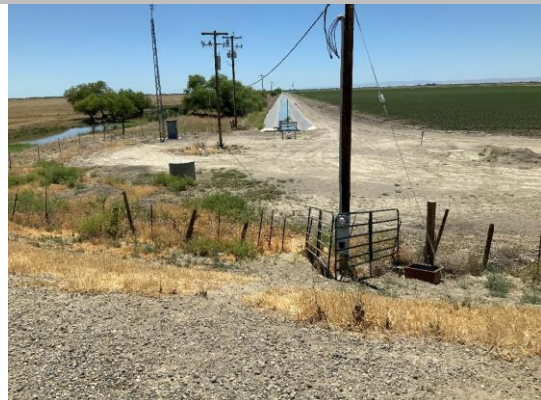
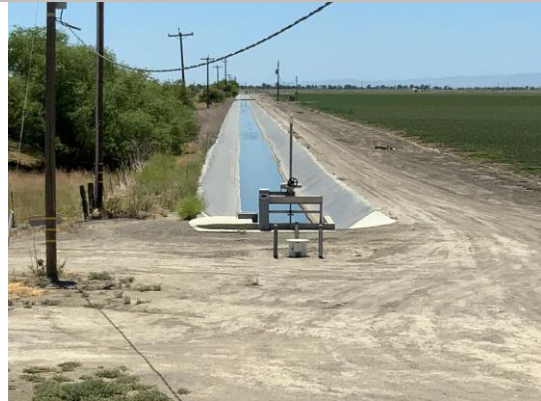
Comment Code						
Inspector Comment						
FS_ID:68237 DS_ID:19906 EP_NO: N/A Repair Type: Non-Urgent Crossing Status: Indicator Found UCIP Comments: 06/8/2021 The record remains Non-Urgent. The slidegate and canal are visible on the LS from the crown, but inaccessible due to fence. Unable to measure and confirm whether the slidegate goes to this crossing. Pipe goes under channel, so not visible on WS. Confirm with owner on the status of this pipe. No permit was found authorizing this encroachment. CVFPB will need to review crossing to determine owner. The UCIP inspection was completed with GEI staff, P. Espinoza. (H. Dunn ? GEI) 04/18/2014 Unable to confirm if crossing recorded as Unit 6 9.735 is the same as this one. No way to measure diameter crossing has slide gate on landward side. (O. Magana - DWR UCIP) FIELD_STRUCT_DESC: [Eastside Canal Siphon] 48-inch corrugated metal irrigation siphon pipe through the levee and under the channel, 17.5 feet below the crown. Slide gate on the landside (LS). [Additional Reference(s): DWR Levee Log, 2002 (HLM 3.36), listed as a 48-inch corrugated metal pipe (CMP). USACE San Joaquin O&M Manual, Unit 601 Part 1 (SJR601.1), 1967, (HLM 3.36), listed as a 48-inch CMP]. FS Date: 6/8/2021

LM Start	3.33	Rating **	M	Issue No.	8 (cont)
LM End	3.33	Issue Type +	En	Location *	
Category	Supplemental			GPS Latitude/Longitude	
				Start	End
Item	DWR UCIP Field Study			37.200954 °	37.200954 °
				-120.694795 °	-120.694795 °
DWR ID	19906

LS view: Close up of slidegate and canal at toe.

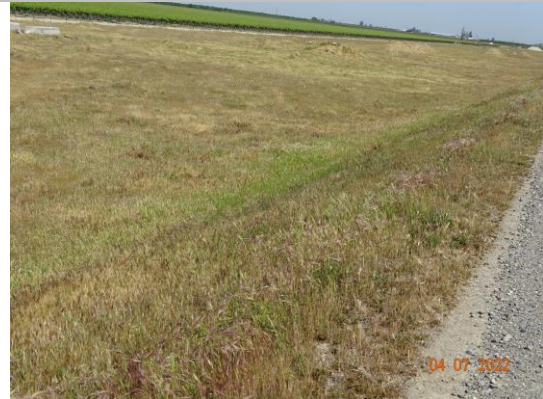
Photo 1 of 1 : SP_2022_NA0010_131_7_20220414_00013.jpg

LM Start	0.30	Rating **	M	Issue No.	7
LM End	1.25	Issue Type +	Ma	Location *	LS
Category	Earthen Levee			GPS Latitude/Longitude	
				Start	End
Item	Vegetation			37.037779 °	37.046300 °
				-120.440413 °	-120.428143 °
DWR ID	DWR_NA0010_13_s_2022_7				
Comment Code					
V1 : Control annual grass and weeds on the levee slopes and easements.					
Inspector Comment

View of vegetation on the landside slope. (Spring 2022)

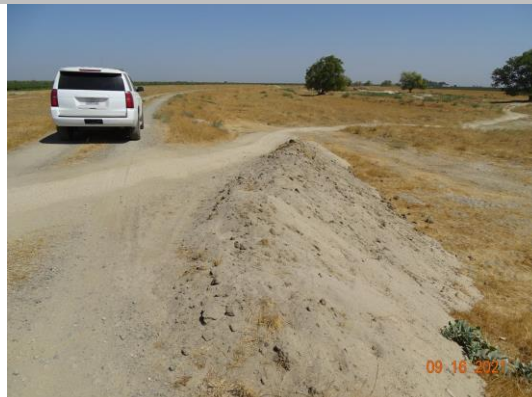
Photo 1 of 1 : SP_2022_NA0010_131_10_20220308_00005.jpg

LM Start	0.48	Rating **	M	Issue No.	10
LM End	0.48	Issue Type +	En	Location *	WS
Category	Earthen Levee			GPS Latitude/Longitude	
				Start	End
Item	Encroachments			37.040347 °	37.040347 °
				-120.439312 °	-120.439312 °
DWR ID	DWR_NA0010_13_f_2021_10				
Comment Code					
RA : Ramp					
Inspector Comment

View of unauthorized ramp on the waterside slope. (Fall 2021)

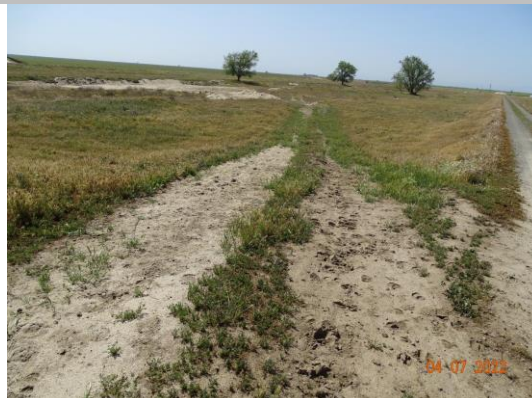
Photo 1 of 1 : SP_2022_NA0010_131_12_20220414_00015.jpg

LM Start	0.72	Rating **	M	Issue No.	12
LM End	0.72	Issue Type +	En	Location *	WS
Category	Earthen Levee			GPS Latitude/Longitude	
				Start	End
Item	Encroachments			37.042891 °	37.042891 °
				-120.436577 °	-120.436577 °
DWR ID	DWR_NA0010_13_s_2022_12				
Comment Code					
RA : Ramp					
Inspector Comment

Unauthorized ramp constructed on the waterside slope. (Spring 2022)

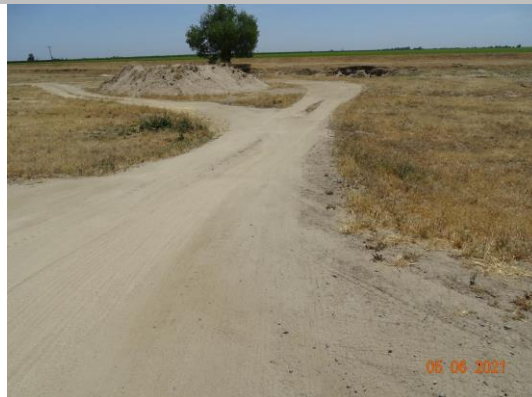
Photo 1 of 1 : SP_2022_NA0010_131_5_20220308_00002.jpg

LM Start	0.91	Rating **	M	Issue No.	5
LM End	0.91	Issue Type +	En	Location *	WS
Category	Earthen Levee			GPS Latitude/Longitude	
				Start	End
Item	Encroachments			37.044855 °	37.044855 °
				-120.434106 °	-120.434106 °
DWR ID	DWR_NA0010_13_s_2014_5				
Comment Code					
RA : Ramp					
Inspector Comment					
There is an unauthorized ramp on waterside slope. Access ramp on the landside is shown in as-built drawings.

Unauthorized ramp constructed on the waterside slope. (Spring 2021)

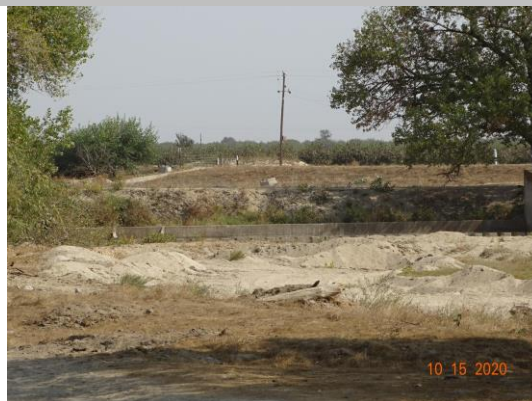
Photo 1 of 1 : SP_2022_NA0010_131_6_20220308_00003.jpg

LM Start	1.14	Rating **	U	Issue No.	6
LM End	1.14	Issue Type +	En	Location *	WS
Category	Earthen Levee			GPS Latitude/Longitude	
				Start	End
Item	Encroachments			37.045541 °	37.045541 °
				-120.430014 °	-120.430014 °
DWR ID	DWR_NA0010_13_f_2015_6				
Comment Code					
WL : Wall					
Inspector Comment					
Sand dam may have been blown out due to high flows in 2017 but has been restored. The sand dam referenced in this issue is an unauthorized construction in the channel by the landowner. It blocks the entire channel.

Downstream view of sand dam constructed upstream of the Ash Slough Drop Structure 4. (Fall 2020)

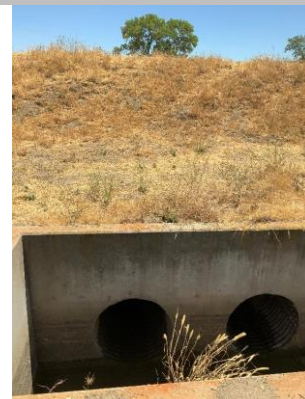
Comment Code						
Inspector Comment						
FS_ID:69821 DS_ID:19727 EP_NO: N/A Repair Type: Non-Urgent Crossing Status: Found UCIP Comments: 06/23/2021 The record remains Non-Urgent. Appears abandoned due to actuator missing on slidegate on the WS shoulder and if abandoned, should be done properly. Limited inspection of inlet and outlet due to standing water over concrete platforms surrounding pipe inlet/outlet, creating inability to inspect closely. No permit was found authorizing this encroachment. CVFPB will need to review crossing to determine owner. The UCIP inspection was completed with GEI staff, H.Dunn. (P.Espinoza ? GEI)03/27/2014 Appears abandoned and if so should be done so properly. Pipe filled with soil on WS at outlet. Actuator missing from slide gate on WS shoulder. (W. Wylie - DWR UCIP) FIELD_STRUCT_DESC: [Rounder Irrigation Structure] 1 of 2: 36-inch corrugated metal gravity drainage pipe through the levee, 12.3 feet below the crown. Slide gate in a 48-inch corrugated metal pipe (CMP) riser on the waterside (WS) slope. 6-foot by 12-foot concrete distribution box on the landside (LS). 7-foot by 14-foot concrete outlet structure on the WS toe. [Additional Reference(s): DWR Levee Log, 2002 (HLM 1.14), listed as a 36-inch corrugated metal pipe (CMP). USACE San Joaquin O&M Manual, Unit 601 Part 1 (SJR601.1), 1967, (HLM 1.14), listed as a 36-inch CMP]. FS Date: 6/23/2021 1:08:00 PM

LS view: concrete inlet pipe on LS toe.

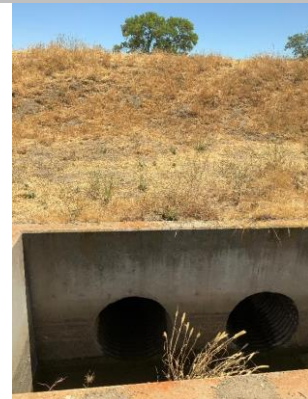
LM Start	1.14	Rating **	M	Issue No.	2 (cont)
LM End	1.14	Issue Type +	Ma	Location *	
Category	Supplemental		GPS Latitude/Longitude		
			Start	End	
Item	DWR UCIP LMA Responsibility		37.045870 °	37.045870 °	
			-120.430080 °	-120.430080 °	
DWR ID	19908

LS view: Slope and headwall from toe.

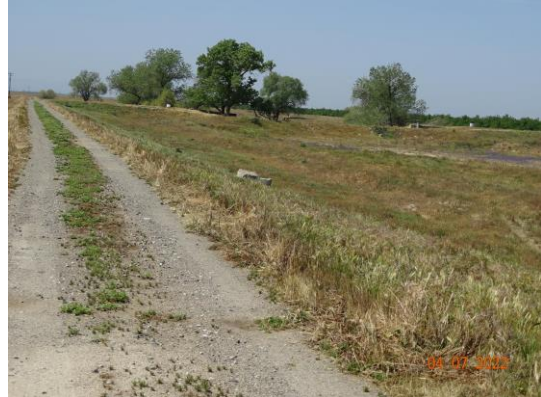
Photo 1 of 1 : SP_2022_NA0010_132_8_20220414_00011.jpg

LM Start	0.01	Rating **	M	Issue No.	8
LM End	1.26	Issue Type +	Ma	Location *	WS
Category	Earthen Levee			GPS Latitude/Longitude	
				Start	End
Item	Vegetation			37.032449 °	37.045399 °
				-120.441252 °	-120.427793 °
DWR ID	DWR_NA0010_14_s_2022_8				
Comment Code					
V1 : Control annual grass and weeds on the levee slopes and easements.					
Inspector Comment

View of vegetation on the waterside slope looking downstream. (Spring 2022)

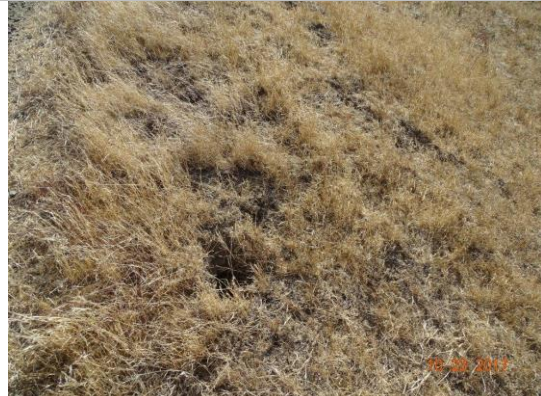
Photo 1 of 1 : SP_2022_NA0010_132_5_20220308_00002.jpg

LM Start	0.25	Rating **	A/W	Issue No.	5
LM End	0.25	Issue Type +	Ma	Location *	LS
Category	Earthen Levee			GPS Latitude/Longitude	
				Start	End
Item	Animal Control			37.035841 °	37.035841 °
				-120.439795 °	-120.439795 °
DWR ID	DWR_NA0010_14_f_2017_5				
Comment Code					
A3 : No rodents visible, but rodent burrows visible; need to backfill and compact or grout burrows.					
Inspector Comment

Looking at the landside slope.

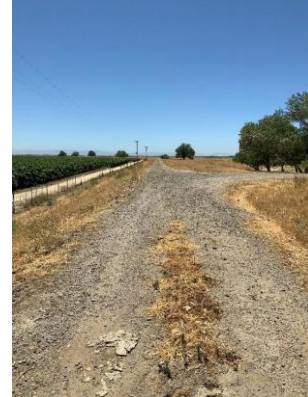
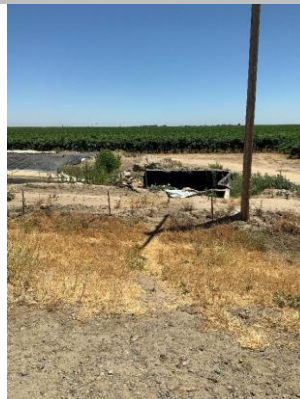
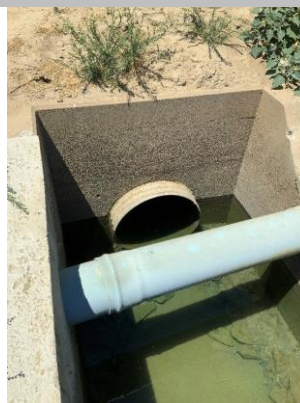
Comment Code						
Inspector Comment						
FS_ID:69943 DS_ID:19909 EP_NO: N/A Repair Type: Non-Urgent Crossing Status: Found UCIP Comments: 06/23/2021 The record remains Non-Urgent. DWR DMP internal inspection has found pipe integrity issues. LOF of crossing is between 4.1 and 5. Crossing will be monitored until funding becomes available for rehabilitation. CMP riser on WS slope is missing lid, causing a safety concern. Limited inspection of both inlet and outlet due to elevated standing water in concrete boxes surrounding inlet/outlet, limiting closeup inspection of pipe. No permit was found authorizing this encroachment. CVFPB will need to review crossing to determine owner. The UCIP inspection was completed with GEI staff, H.Dunn. (P.Espinoza ? GEI)03/27/2014 Lid should be installed on CMP riser on WS slope, could be a safety hazard. Also dense vegetation limits the inspector's visibility to identify signs of pipe failure (leaks) along the slope. Recommend removing vegetation along pipe alignment to conduct proper inspection of structure. (O. Magana - DWR UCIP) FIELD_STRUCT_DESC: [Rounder Irrigation Structure] 36-inch corrugated metal gravity irrigation pipe through the levee, 10 feet below the crown. Slide gate in a 48-inch corrugated metal pipe (CMP) riser on the waterside (WS) slope. 6-foot by 7-foot concrete distribution box at the WS toe. Slots for wooden flashboards on the WS of the box. 7-foot by 9-foot concrete distribution box on the landside (LS), 20 feet from the toe. [Additional Reference(s): DWR Levee Log, 2002 (HLM 1.15), listed as a 36-inch corrugated metal pipe (CMP). USACE San Joaquin O&M Manual, Unit 601 Part 1 (SJR601.1), 1967, (HLM 1.15), listed as a 36-inch CMP]. FS Date: 6/23/2021

LM Start	1.15	Rating **	M	Issue No.	1 (cont)
LM End	1.15	Issue Type +	En	Location *	
Category	Supplemental		GPS Latitude/Longitude		
			Start	End	
Item	DWR UCIP Field Study		37.044906 °	37.044906 °	
			-120.429695 °	-120.429695 °	
DWR ID	19909

LS view from crown. Concrete headwall visible in background.

LS view: Concrete box and inlet pipe.

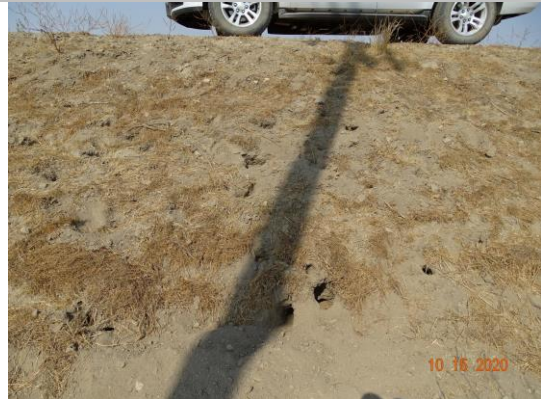
Photo 1 of 1 : SP_2022_NA0010_132_79_20220308_00004.jpg

LM Start	1.24	Rating **	M	Issue No.	79
LM End	1.24	Issue Type +	Ma	Location *	LS
Category	Earthen Levee			GPS Latitude/Longitude	
				Start	End
Item	Animal Control			37.045343 °	37.045343 °
				-120.428007 °	-120.428007 °
DWR ID	DWR_NA0010_14_s_2021_79				
Comment Code					
A3 : No rodents visible, but rodent burrows visible; need to backfill and compact or grout burrows.					
Inspector Comment					
Several rodent holes are noted on the landside at this location.

View of rodent burrows on the landside slope. (Fall 2020)

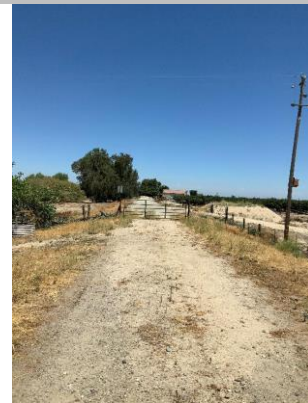
Photo 1 of 3 : UCIP_SP_2022_69824_103809.jpg

Comment Code						
Inspector Comment						
FS_ID:69824 DS_ID:19910 EP_NO: N/A Repair Type: Urgent Crossing Status: Found UCIP Comments: 06/23/2021 Record has been upgraded from No Action Needed to Urgent. DWR DMP internal inspection has found pipe integrity issues. LOF of crossing is between 5 and 6. Crossing will be monitored until funding becomes available to address the issues. Lid missing from CMP riser on WS slope, causing safety concern. LS not accessible; limited inspection due to barbed wire. No permit was found authorizing this encroachment. CVFPB will need to review crossing to determine owner. The UCIP inspection was completed with GEI staff, H.Dunn. (P.Espinoza ? GEI) FIELD_STRUCT_DESC: 36-inch corrugated metal gravity drainage pipe through the levee, 9 feet below the crown. Slide gate in a 42-inch corrugated metal pipe (CMP) riser on the waterside (WS) slope. Concrete U-shaped headwall on the WS end. Pipe terminates into a concrete ditch on the landside (LS). [Additional Reference(s): DWR Levee Log, 2002 (HLM 1.26), listed as a 36-inch corrugated metal pipe (CMP). USACE San Joaquin O&M Manual, Unit 601 Part 1 (SJR601.1), 1967, (HLM 1.26), listed as a 36-inch CMP]. FS Date: 6/23/2021 2:07:00 PM

View from levee crown.

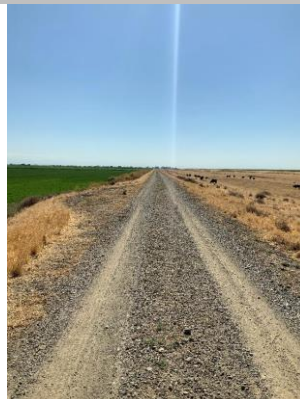
Photo 1 of 3 : UCIP_SP_2022_69825_103817.jpg

Comment Code						
Inspector Comment						
FS_ID:69825 DS_ID:19911 EP_NO: N/A Repair Type: Non-Urgent Crossing Status: Indicator Found UCIP Comments: 06/24/2021 The record has been upgraded from No Action Needed to Non-Urgent. Limited inspection of LS due to vegetation overgrowth; recommend removal. Water was actively flowing through WS pipe. No permit was found authorizing this encroachment. CVFPB will need to review crossing to determine owner. The UCIP inspection was completed with GEI staff, H.Dunn. (P.Espinoza ? GEI) FIELD_STRUCT_DESC: 30-inch by 30-inch square reinforced concrete box gravity drainage culvert through the levee, 10.1 feet below the crown. Flap gate on the waterside (WS) end. Concrete headwall on the landside (LS) end. Concrete U-shaped headwall on the WS end. [Additional Reference(s): DWR Levee Log, 2002 (HLM 0.49), listed as a 30-inch square reinforced concrete box culvert (RCBC). USACE San Joaquin O&M Manual, Unit 601 Part 1 (SJR601.1), 1967, (HLM 0.48), listed as a 2.5-feet by 2.5-feet RCBC]. FS Date: 6/24/2021 2:52:00 PM

view of levee crown.

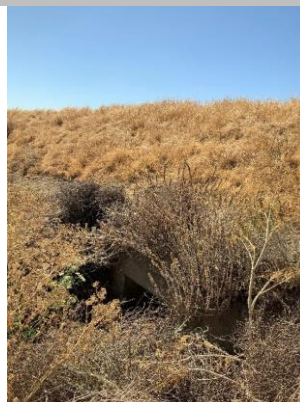
Photo 2 of 3 : UCIP_SP_2022_69825_103819.jpg

LS view: concrete wall and entrance to pipe from toe. View of slope in background.

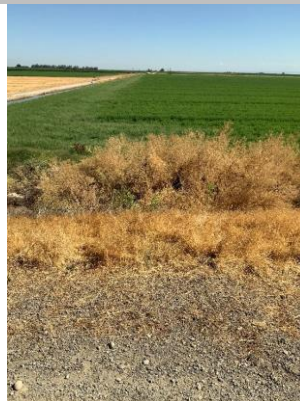
Photo 3 of 3 : UCIP_SP_2022_69825_103818.jpg

WS view: slope from crown.

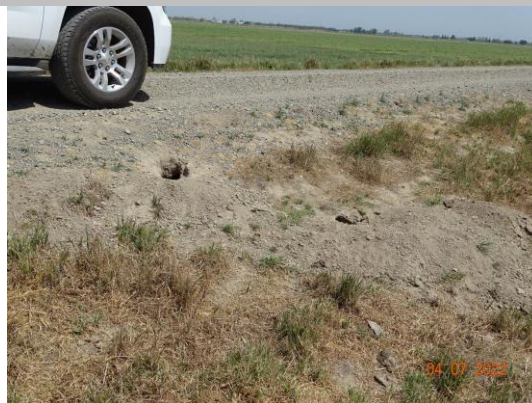
Photo 1 of 1 : SP_2022_NA0010_133_6_20220414_00013.jpg

LM Start	0.95	Rating **	M	Issue No.	6
LM End	0.95	Issue Type +	Ma	Location *	WS
Category	Earthen Levee			GPS Latitude/Longitude	
				Start	End
Item	Animal Control			36.996555 °	36.996555 °
				-120.393195 °	-120.393195 °
DWR ID	DWR_NA0010_15_s_2022_6				
Comment Code					
A1 : Exterminate rodents and backfill and compact or grout burrows.					
Inspector Comment					
Burrows on both landside and waterside slopes.

View of rodent holes in the waterside slope. (Spring 2022)

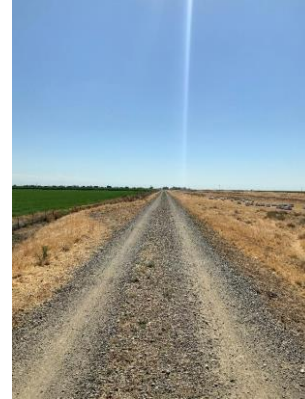
Photo 1 of 3 : UCIP_SP_2022_69727_103822.jpg

Comment Code						
Inspector Comment						
FS_ID:69727 DS_ID:19912 EP_NO: N/A Repair Type: Non-Urgent Crossing Status: Found UCIP Comments: 06/24/2021 The record remains Non-Urgent. Limited inspection of LS pipe due to vegetation overgrowth; recommend removal. No permit was found authorizing this encroachment. CVFPB will need to review crossing to determine owner. The UCIP inspection was completed with GEI staff, H.Dunn. (P.Espinoza ? GEI) 03/27/2014 Dense vegetation limits the inspector's visibility to identify signs of pipe failure (leaks) along the landward slope. Recommend removing vegetation along pipe alignment to conduct proper inspection of structure. (W. Wylie - DWR UCIP) FIELD_STRUCT_DESC: 30-inch by 30-inch square reinforced concrete box gravity drainage culvert through the levee, 8.5 feet below the crown. Flap gate on the waterside (WS) end. Concrete headwall on the landside (LS) end. Concrete U-shaped headwall on the WS end. [Additional Reference(s): DWR Levee Log, 2002 (HLM 1.01), listed as a 30-inch square reinforced concrete box culvert (RCBC). USACE San Joaquin O&M Manual, Unit 601 Part 1 (SJR601.1), 1967, (HLM 1.01), listed as a 2.5-feet by 2.5-feet RCBC]. FS Date: 6/24/2021 3:18:00 PM

view of levee crown

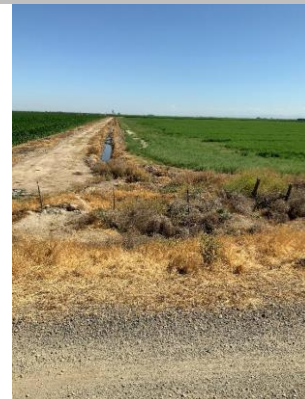
Photo 2 of 3 : UCIP_SP_2022_69727_103823.jpg

LS view: toe from levee crown

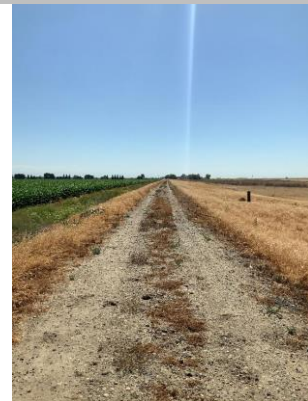
Photo 1 of 3 : UCIP_SP_2022_69728_103828.jpg

FS_ID:69728
DS_ID:19913
EP_NO: N/A
Repair Type: Non-Urgent
Crossing Status: Found
UCIP Comments: 06/24/2021 The record remains Non-Urgent. Limited inspection of LS pipe due to vegetation overgrowth; recommend removal. Note that wooden board is holding flapgate closed on WS; recommend removing before flood season to allow for flow. No permit was found authorizing this encroachment. CVFPB will need to review crossing to determine owner. The UCIP inspection was completed with GEI staff, H.Dunn. (P.Espinoza ? GEI) 03/27/2014 Excessive vegetation at inlet on LS toe. (W. Wylie - DWR UCIP)
FIELD_STRUCT_DESC: 30-inch by 30-inch square reinforced concrete box gravity drainage culvert through the levee, 8.9 feet below the crown. Flap gate on the waterside (WS) end. Concrete headwall on the landside (LS) end. Concrete U-shaped headwall on the WS end.
[Additional Reference(s): DWR Levee Log, 2002 (HLM 1.54), listed as a 30-inch square reinforced concrete box culvert (RCBC). USACE San Joaquin O&M Manual, Unit 601 Part 1 (SJR601.1), 1967, (HLM 1.53), listed as a 2.5-feet by 2.5-feet RCBC].

view of levee crown.

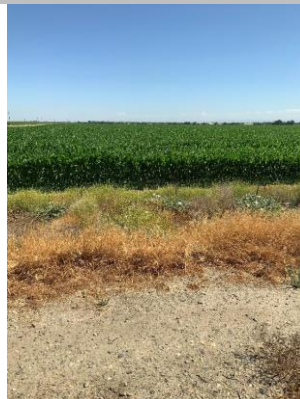
Photo 2 of 3 : UCIP_SP_2022_69728_103829.jpg

LS view of toe from levee crown.
