**Flood Control Project Maintenance
Levee Inspections
LMA District Cover Sheet**

Lower San Joaquin Levee District

**Flood Control Project Maintenance
Levee Inspections
Unit Cover Sheet**

Levee Inspection Report By Mile - Spring 2022

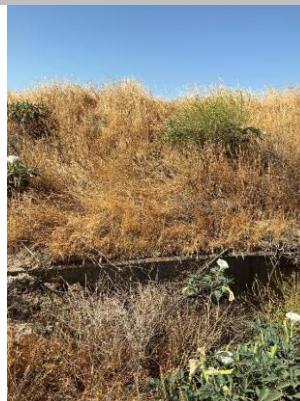
Photo 3 of 3 : UCIP_SP_2022_69728_103831.jpg

LS view: concrete headwall from toe.

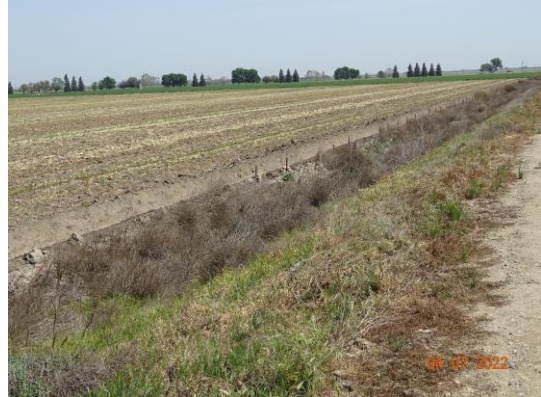
Photo 1 of 1 : SP_2022_NA0010_133_7_20220414_00014.jpg

LM Start	1.60	Rating **	M	Issue No.	7
LM End	2.01	Issue Type +	Ma	Location *	LS
Category	Earthen Levee			GPS Latitude/Longitude	
				Start	End
Item	Vegetation			36.996587 °	36.996613 °
				-120.381540 °	-120.374046 °
DWR ID	DWR_NA0010_15_s_2022_7				
Comment Code					
V1 : Control annual grass and weeds on the levee slopes and easements.					
Inspector Comment

Looking downstream along the landside slope. (Spring 2022)

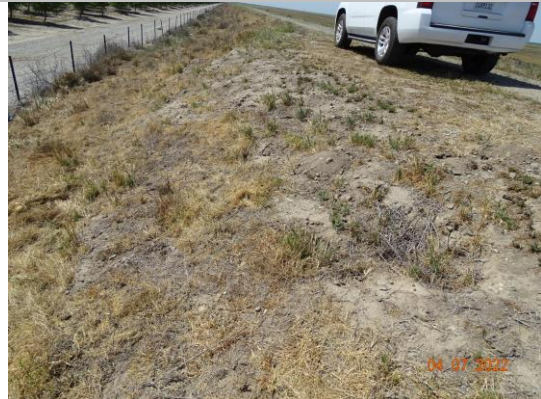
Photo 1 of 1 : SP_2022_NA0010_134_92_20220414_00011.jpg

LM Start	0.93	Rating **	M	Issue No.	92
LM End	0.93	Issue Type +	Ma	Location *	LS
Category	Earthen Levee			GPS Latitude/Longitude	
				Start	End
Item	Animal Control			36.995439 °	36.995439 °
				-120.392146 °	-120.392146 °
DWR ID	DWR_NA0010_16_s_2015_92				
Comment Code					
A3 : No rodents visible, but rodent burrows visible; need to backfill and compact or grout burrows.					
Inspector Comment					
Several rodent holes are identified within this section.

Looking at several rodent holes on landward slope. (Spring 2022)

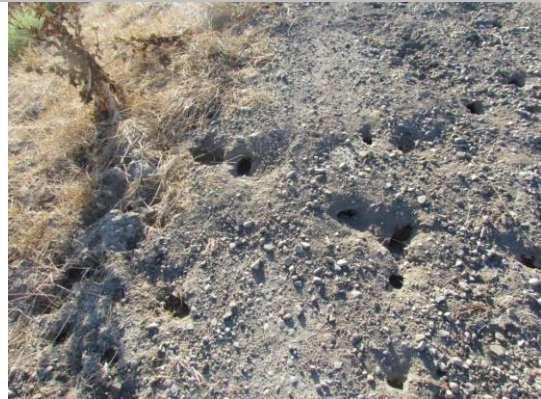
Photo 1 of 1 : SP_2022_NA0010_134_3_20220308_00002.jpg

LM Start	1.09	Rating **	M	Issue No.	3
LM End	1.09	Issue Type +	Ma	Location *	CR
Category	Earthen Levee			GPS Latitude/Longitude	
				Start	End
Item	Animal Control			36.995433 °	36.995433 °
				-120.389190 °	-120.389190 °
DWR ID	DWR_NA0010_16_f _ 2016_3				
Comment Code					
A3 : No rodents visible, but rodent burrows visible; need to backfill and compact or grout burrows.					
Inspector Comment					
Several rodent holes are identified on the levee crown.

Looking at several rodent holes and mole holes on levee crown.

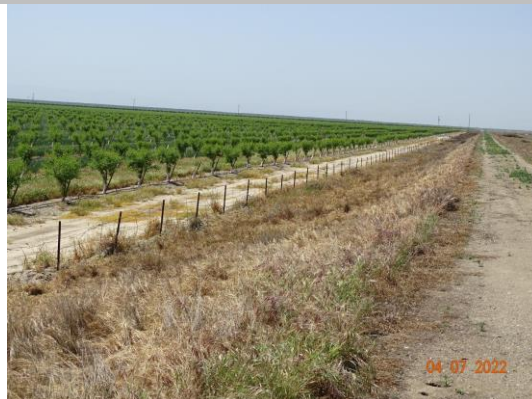
Photo 1 of 1 : SP_2022_NA0010_134_5_20220414_00012.jpg

LM Start	1.40	Rating **	M	Issue No.	5
LM End	1.95	Issue Type +	Ma	Location *	LS
Category	Earthen Levee			GPS Latitude/Longitude	
				Start	End
Item	Vegetation			36.995487 °	36.995500 °
				-120.383748 °	-120.373700 °
DWR ID	DWR_NA0010_16_s_2022_5				
Comment Code					
V1 : Control annual grass and weeds on the levee slopes and easements.					
Inspector Comment

Looking vegetation on the landside slope. (Spring 2022)

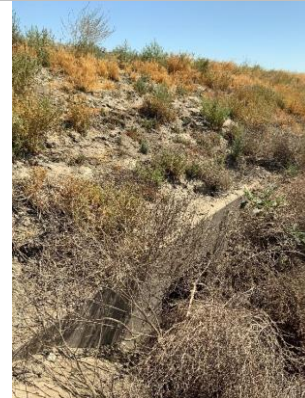
Photo 2 of 3 : UCIP_SP_2022_69769_103851.jpg

LS view: Slope and concrete headwall at inlet, covered by heavy vegetation.

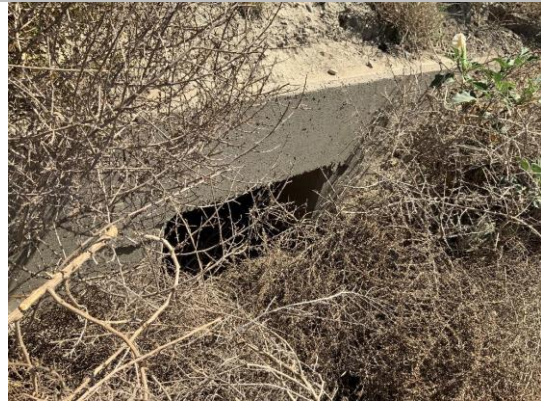
Photo 3 of 3 : UCIP_SP_2022_69769_103852.jpg

LS view: close up of concrete headwall at inlet.

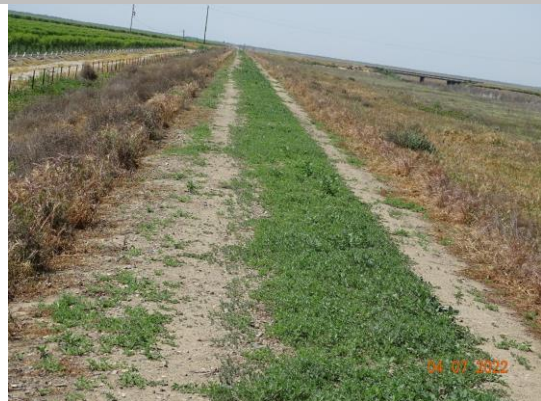
Photo 1 of 1 : SP_2022_NA0010_134_8_20220414_00013.jpg

LM Start	1.65	Rating **	M	Issue No.	8
LM End	1.84	Issue Type +	Ma	Location *	CR
Category	Earthen Levee			GPS Latitude/Longitude	
				Start	End
Item	Vegetation			36.995498 °	36.995502 °
				-120.379192 °	-120.375747 °
DWR ID	DWR_NA0010_16_s_2022_8				
Comment Code					
V9 : Keep the crown roadway free of vegetation.					
Inspector Comment

Looking downstream along the levee crown. (Spring 2022)

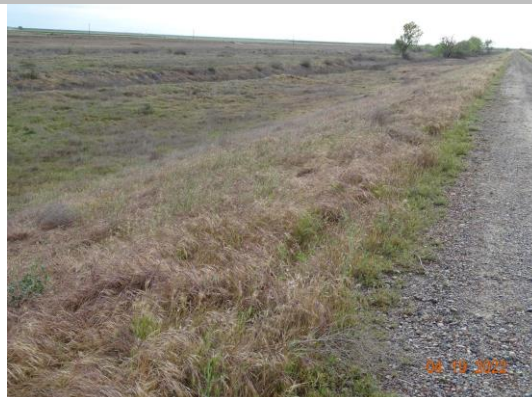
Photo 1 of 1 : SP_2022_NA0010_135_14_20220502_00040.jpg

LM Start	0.00	Rating **	M	Issue No.	14
LM End	2.56	Issue Type +	Ma	Location *	LS
Category	Earthen Levee			GPS Latitude/Longitude	
				Start	End
Item	Vegetation			36.976437 °	36.952462 °
				-120.374767 °	-120.348948 °
DWR ID	DWR_NA0010_17_s_2022_14				
Comment Code					
V1 : Control annual grass and weeds on the levee slopes and easements.					
Inspector Comment

View of vegetation growing along the landside slope. (Spring 2022)

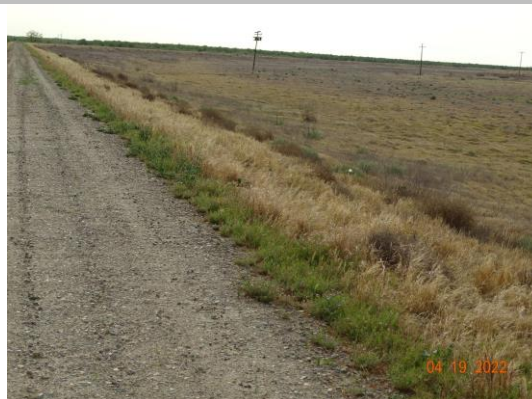
Photo 1 of 1 : SP_2022_NA0010_135_15_20220502_00041.jpg

LM Start	0.03	Rating **	M	Issue No.	15
LM End	2.56	Issue Type +	Ma	Location *	WS
Category	Earthen Levee			GPS Latitude/Longitude	
				Start	End
Item	Vegetation			36.976441 °	36.952462 °
				-120.374245 °	-120.348948 °
DWR ID	DWR_NA0010_17_s_2022_15				
Comment Code					
V1 : Control annual grass and weeds on the levee slopes and easements.					
Inspector Comment

Looking upstream along the waterside slope. (Spring 2022)

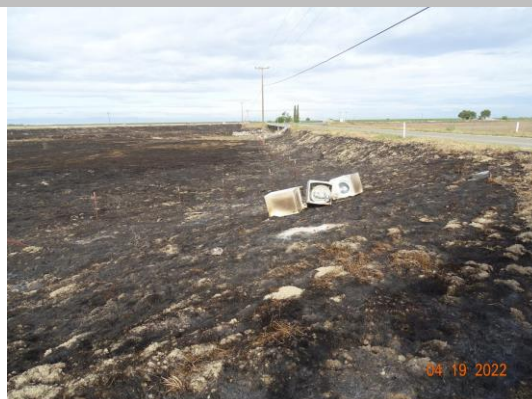
Photo 1 of 1 : SP_2022_NA0010_135_16_20220502_00042.jpg

LM Start	2.56	Rating **	M	Issue No.	16
LM End	2.56	Issue Type +	En	Location *	WS
Category	Earthen Levee			GPS Latitude/Longitude	
				Start	End
Item	Encroachments			36.952462 °	36.952462 °
				-120.348948 °	-120.348948 °
DWR ID	DWR_NA0010_17_s_2022_16				
Comment Code					
GA : Garbage					
Inspector Comment

Washing machines discarded on the waterside slope. (Spring 2022)

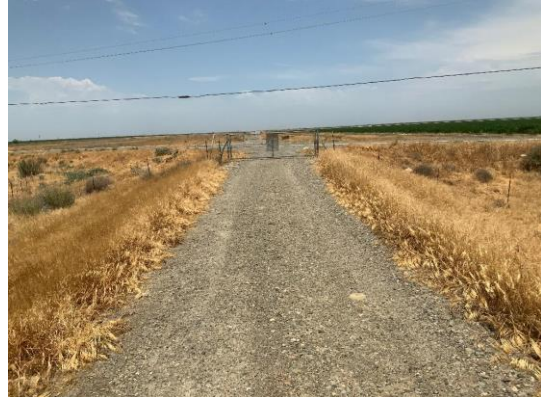
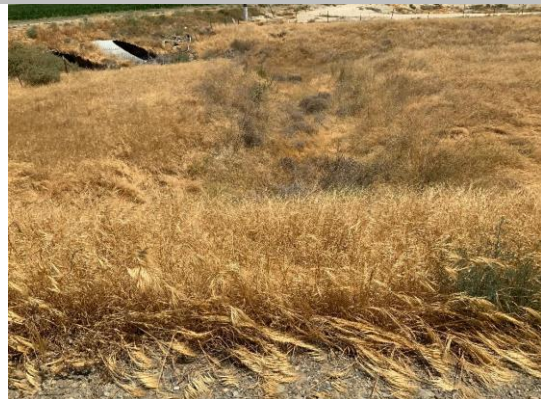
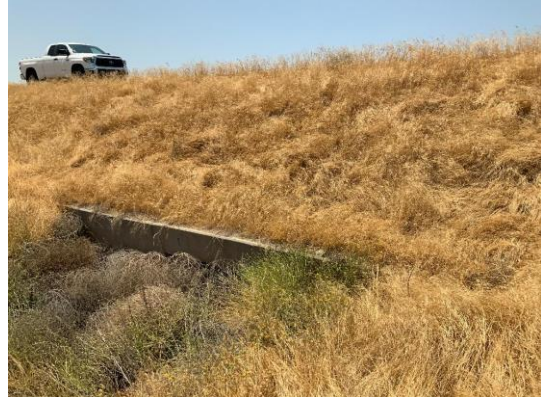
FS_ID:68828
DS_ID:19916
EP_NO: N/A
Repair Type: Non-Urgent
Crossing Status: Found
UCIP Comments: 07/13/2021 The record remains Non-Urgent. Limited inspection due to tumbleweeds blocking LS pipe inlet, recommend removal. No permit was found authorizing this encroachment. CVFPB will need to review crossing to determine owner. The UCIP inspection was completed with GEI staff, P. Espinoza. (H. Dunn ? GEI)

04/01/2014 Dense vegetation limits the inspector's visibility to identify signs of pipe failure (leaks) along the landward slope. Recommend removing vegetation along pipe alignment to conduct proper inspection of structure. (W. Wylie - DWR UCIP)
FIELD_STRUCT_DESC: 48-inch by 60-inch reinforced concrete box gravity drainage culvert through the levee, 14.6 feet below the crown. Flap gate on the waterside (WS) end. Concrete headwall on the landside (LS) end. Concrete U-shaped headwall on the WS end.
[Additional Reference(s): DWR Levee Log, 2002 (HLM 2.58), listed as a 48-inch by 60-inch reinforced concrete box culvert (RCBC). USACE San Joaquin O&M Manual, Unit 601 Part 1 (SJR601.1), 1967, (HLM 2.58), listed as a 5-feet by 4-feet RCBC].
FS Date: 7/19/2021

Levee crown.

LS view: Toe from crown.

LS view: Slope from toe.

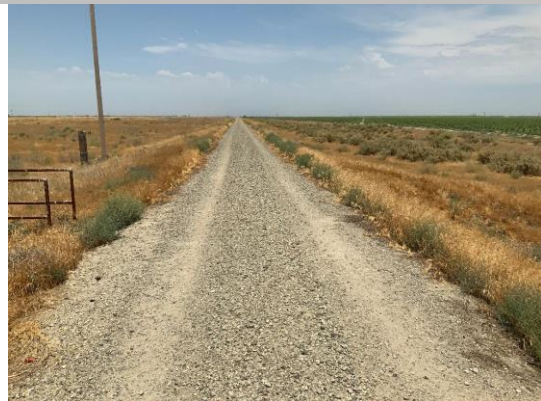
FS_ID:68516
 DS_ID:19921
 EP_NO: 13587
 Repair Type: Non-Urgent
 Crossing Status: Found
 UCIP Comments: 07/13/2021 The record has been upgraded from No Action Needed to Non-Urgent. Dense vegetation over the WS gate, recommend clearing out for better flow during flood season. Some minor vegetation over LS pipe inlet, recommend removal. The UCIP inspection was completed with GEI staff, P. Espinoza. (H. Dunn ? GEI)
 FIELD_STRUCT_DESC: 48-inch by 60-inch reinforced concrete box gravity drainage culvert through the levee, 14.6 feet below the crown. Concrete U-shaped headwall on the waterside (WS) end. 36-inch weir structure on the WS. Combination flap gate and slide gate on the WS toe. Steel walkway to slide gate actuator on the WS shoulder. (Plans to construct a 3.281-foot-high weir and attach a cable operated flap valve to an existing 48-inch by 60-inch culvert authorized under Permit No. 13587, 1983 - Clark Brothers Farming, Arroyo Ranch). [Additional Reference(s): DWR Levee Log, 2002 (HLM 4.68), listed as a 48-inch by 60-inch reinforced concrete box culvert (RCBC). USACE San Joaquin O&M Manual, Unit 601 Part 1 (SJR601.1), 1967, (HLM 4.69), listed as a 5-feet by 4-feet RCBC].

Levee crown.

LS view: Toe from crown.

LS view: Headwall and slope from toe.

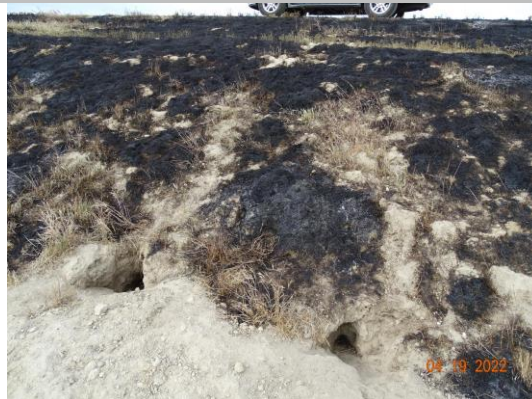
Photo 1 of 1 : SP_2022_NA0010_135_8_20220502_00043.jpg

LM Start	5.75	Rating **	M	Issue No.	8
LM End	5.90	Issue Type +	Ma	Location *	LS
Category	Earthen Levee			GPS Latitude/Longitude	
				Start	End
Item	Animal Control			36.908605 °	36.906507 °
				-120.331112 °	-120.330353 °
DWR ID	DWR_NA0010_17_s_2012_8				
Comment Code					
A1 : Exterminate rodents and backfill and compact or grout burrows.					
Inspector Comment					
Multiple rodent holes are noted on the landside slope and toe.

Looking at several rodent holes on landside slope. (Spring 2022)

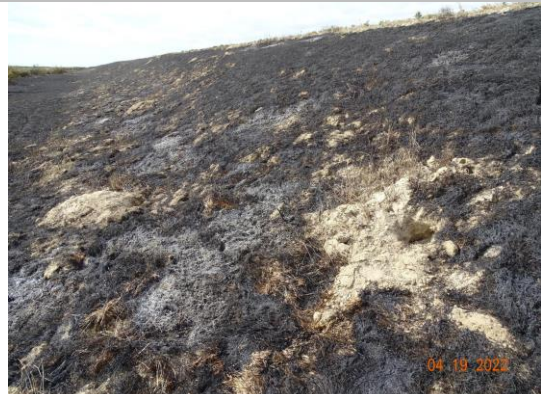
Photo 1 of 1 : SP_2022_NA0010_135_4_20220502_00044.jpg

LM Start	6.51	Rating **	M	Issue No.	4
LM End	6.80	Issue Type +	Ma	Location *	LS
Category	Earthen Levee			GPS Latitude/Longitude	
				Start	End
Item	Animal Control			36.898093 °	36.894147 °
				-120.326689 °	-120.324763 °
DWR ID	DWR_NA0010_17_s_2012_4				
Comment Code					
A1 : Exterminate rodents and backfill and compact or grout burrows.					
Inspector Comment					
Several rodent holes are identified within this reach.

View of rodent holes on the landside slope. (Spring 2022)

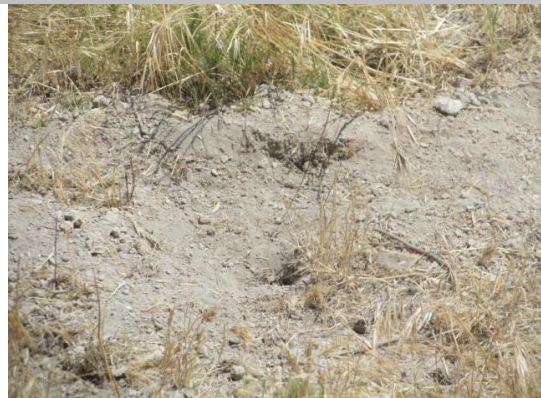
Photo 1 of 1 : SP_2022_NA0010_135_5_20220308_00003.jpg

LM Start	7.27	Rating **	M	Issue No.	5
LM End	7.38	Issue Type +	Ma	Location *	LS
Category	Earthen Levee			GPS Latitude/Longitude	
				Start	End
Item	Animal Control			36.887852 °	36.886388 °
				-120.321668 °	-120.320950 °
DWR ID	DWR_NA0010_17_s_2012_5				
Comment Code					
A3 : No rodents visible, but rodent burrows visible; need to backfill and compact or grout burrows.					
Inspector Comment					
Several rodent holes are identified within this reach.

Looking at typical view of rodent holes on landward slope.

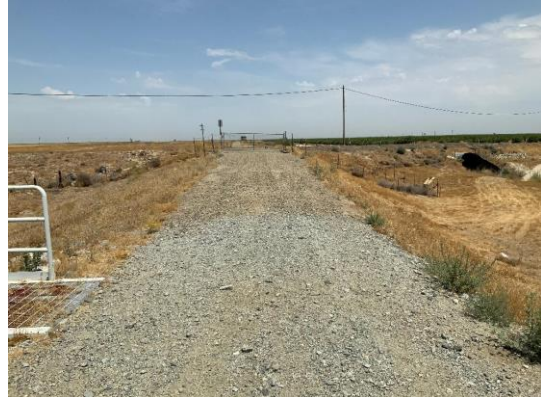
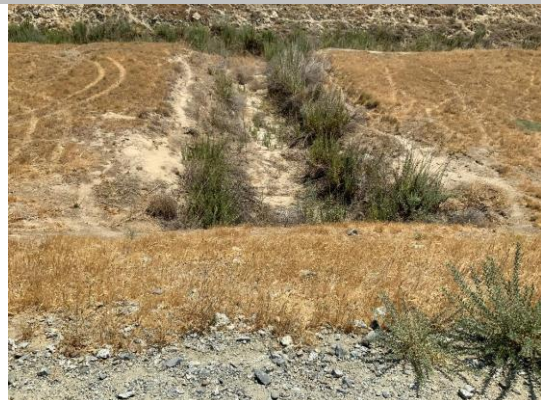
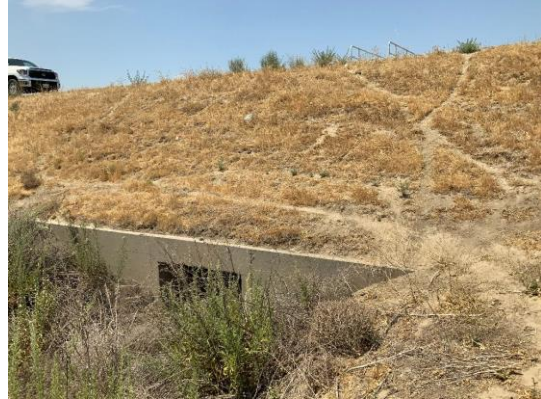
Comment Code						
Inspector Comment						
FS_ID:68829 DS_ID:19922 EP_NO: N/A Repair Type: Non-Urgent Crossing Status: Found UCIP Comments: 07/13/2021 The record has been upgraded from No Action Needed to Non-Urgent. Limited inspection due to dense tumbleweeds over LS pipe inlet, recommend removal. No permit was found authorizing this encroachment. CVFPB will need to review crossing to determine owner. The UCIP inspection was completed with GEI staff, P. Espinoza. (H. Dunn ? GEI) FIELD_STRUCT_DESC: 48-inch by 60-inch reinforced concrete box gravity drainage culvert through the levee, 16.5 feet below the crown. Flap gate on the waterside (WS) end. Concrete headwall on the landside (LS) end. Concrete U-shaped headwall on the WS end. [Additional Reference(s): DWR Levee Log, 2002 (HLM 8.38), listed as a 48-inch by 60-inch reinforced concrete box culvert (RCBC). USACE San Joaquin O&M Manual, Unit 601 Part 1 (SJR601.1), 1967, (HLM 8.38), listed as a 5-feet by 4-feet RCBC]. FS Date: 7/19/2021

Levee crown.

LS view: Toe from crown.

LS view: Headwall and slope from toe.

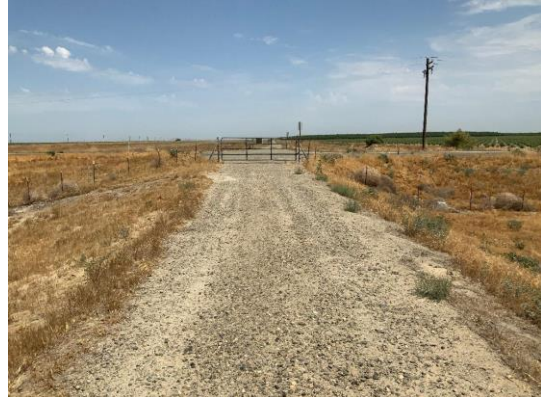
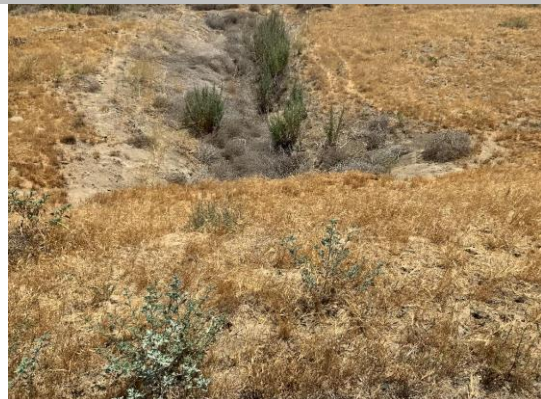
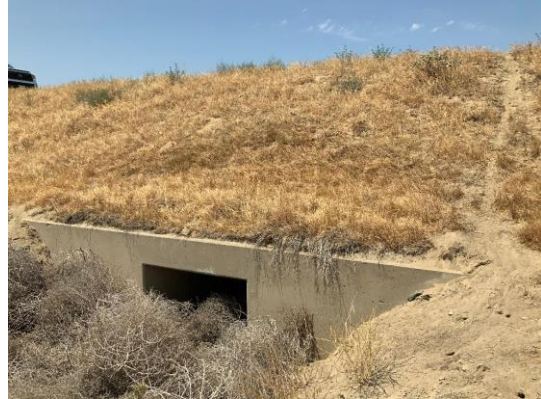
FS_ID:68830
DS_ID:19917
EP_NO: N/A
Repair Type: Non-Urgent
Crossing Status: Found
UCIP Comments: 07/13/2021 The record remains Non-Urgent. Limited inspection due to dense tumbleweeds over LS pipe inlet, recommend removal. No permit was found authorizing this encroachment. CVFPB will need to review crossing to determine owner. The UCIP inspection was completed with GEI staff, P. Espinoza. (H. Dunn ? GEI)

04/01/2014 Dense vegetation limits the inspector's visibility to identify signs of pipe failure (leaks) along the landward slope. Recommend removing vegetation along pipe alignment to conduct proper inspection of structure. (W. Wylie - DWR UCIP)
FIELD_STRUCT_DESC: 48-inch by 60-inch reinforced concrete box gravity drainage culvert through the levee, 15 feet below the crown. Concrete headwall on the landside (LS) end. Concrete U-shaped headwall on the waterside (WS) end. [Additional Reference(s): DWR Levee Log, 2002 (HLM 9.89), listed as a 48-inch by 60-inch reinforced concrete box culvert (RCBC). USACE San Joaquin O&M Manual, Unit 601 Part 1 (SJR601.1), 1967, (HLM 9.89), listed as a 5-feet by 4-feet RCBC].
FS Date: 7/19/2021

Levee crown.

LS view: Toe from crown.

LS view: Headwall and slope from toe.

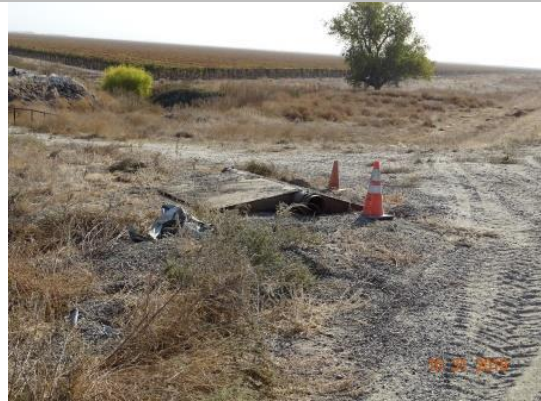
Photo 1 of 1 : SP_2022_NA0010_135_35_20220308_00011.jpg

LM Start	11.03	Rating **	A/W	Issue No.	35
LM End	11.03	Issue Type +	En	Location *	CR
Category	Earthen Levee			GPS Latitude/Longitude	
				Start	End
Item	Encroachments			36.836724 °	36.836724 °
				-120.305328 °	-120.305328 °
DWR ID	DWR_NA0010_17_f_2018_35				
Comment Code					
PI : Pipe					
Inspector Comment					
Temporary pipe and ramp were moved off the levee crown in Fall 2019 and are currently being stored on the waterside slope.

View of ramp and temporary pipe material left on the waterside slope.
(Fall 2019)

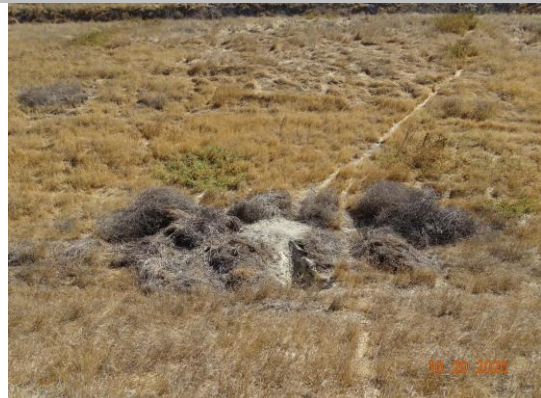
Photo 1 of 1 : SP_2022_NA0010_135_39_20220308_00012.jpg

LM Start	12.17	Rating **	A/W	Issue No.	39
LM End	12.17	Issue Type +	Ma	Location *	LS
Category	Earthen Levee			GPS Latitude/Longitude	
				Start	End
Item	Animal Control			36.822818 °	36.822818 °
				-120.299680 °	-120.299680 °
DWR ID	DWR_NA0010_17_f_2018_39				
Comment Code					
A3 : No rodents visible, but rodent burrows visible; need to backfill and compact or grout burrows.					
Inspector Comment					
A large hole is on the landside toe.

Large rodent hole at toe of levee. (Fall 2020)

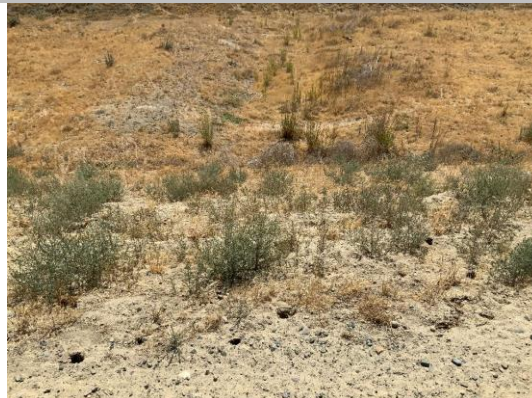
FS_ID:68831
DS_ID:19918
EP_NO: N/A
Repair Type: Non-Urgent
Crossing Status: Found
UCIP Comments: 07/13/2021 The record remains Non-Urgent. WS flapgate has plank holding it shut, remove before flood season. Limited inspection due to dense tumbleweeds covering LS pipe inlet, recommend removal. No permit was found authorizing this encroachment. CVFPB will need to review crossing to determine owner. The UCIP inspection was completed with GEI staff, P. Espinoza. (H. Dunn ? GEI) 04/01/2014 Some vegetation buildup at inlet-- recommend clearing. (W. Wylie - DWR UCIP)
FIELD_STRUCT_DESC: 48-inch by 60-inch reinforced concrete box gravity drainage culvert through the levee, 15.3 feet below the crown. Flap gate on the waterside (WS) end. Concrete headwall on the landside (LS) end. Concrete U-shaped headwall on the WS end.
[Additional Reference(s): DWR Levee Log, 2002 (HLM 13.29), listed as a 48-inch by 60-inch reinforced concrete box culvert (RCBC). USACE San Joaquin O&M Manual, Unit 601 Part 1 (SJR601.1), 1967, (HLM 13.30), listed as a 5-feet by 4-feet RCBC].

Levee crown.

LS view: Headwall visible at toe from crown.

LS view: Headwall and slope from toe.

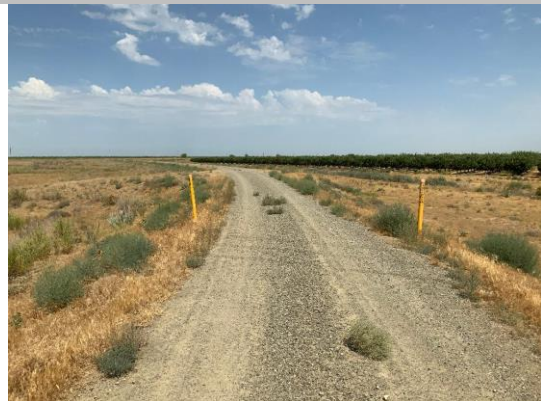
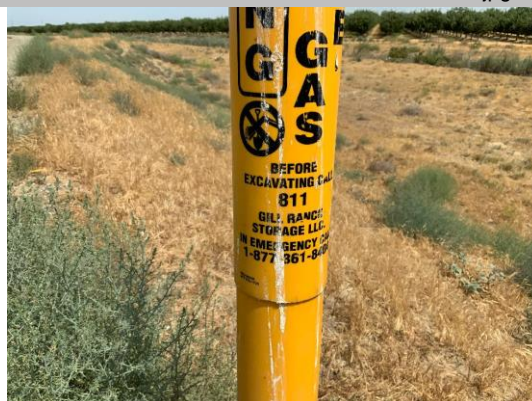
Photo 1 of 3 : UCIP_SP_2022_68519_102441.jpg

FS_ID:68519
 DS_ID:24850
 EP_NO: N/A
 Repair Type: Non-Urgent
 Crossing Status: Indicator Found
 UCIP Comments: 07/13/2021 The record remains Non-Urgent. As a safety measure, need to coordinate with owner to determine status of line and to obtain maintenance and inspection records to confirm integrity of line through the levee. No permit was found authorizing this encroachment. CVFPB will need to review crossing to determine owner. The UCIP inspection was completed with GEI staff, P. Espinoza. (H. Dunn ? GEI) 04/01/2014 No permit identified for this crossing. (W. Wylie - DWR UCIP)
 FIELD_STRUCT_DESC: Natural gas pipeline of an unknown size or material through the levee, at an unknown depth. Gas line markers on both shoulders.
 FS Date: 7/19/2021

Levee crown.

LS view: Marker visible off crown.

LS view: Closeup of contact information on marker.

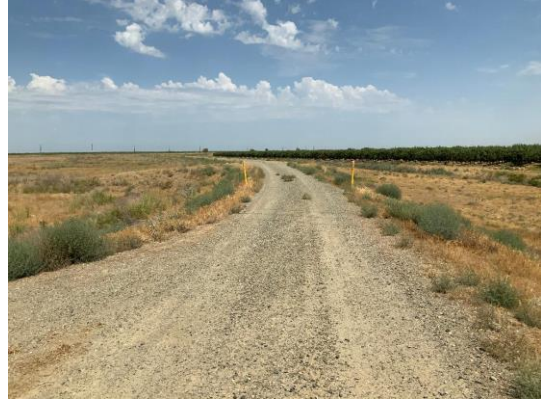
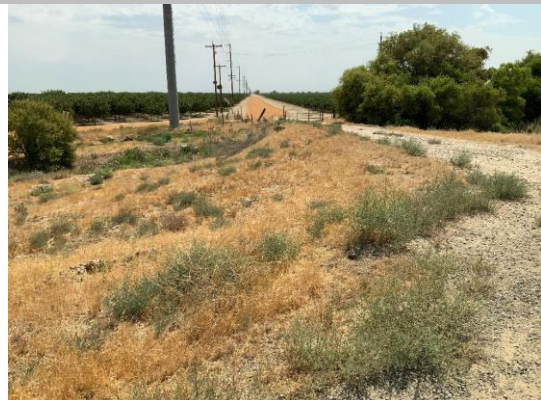
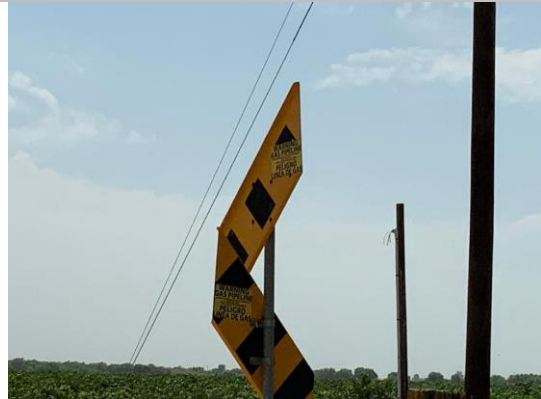
Photo 1 of 3 : UCIP_SP_2022_68520_102450.jpg

Comment Code						
Inspector Comment						
FS_ID:68520 DS_ID:19562 EP_NO: 18568 Repair Type: Non-Urgent Crossing Status: Indicator Found UCIP Comments: 07/19/2021 The record remains Non-Urgent. As a safety measure, need to coordinate with owner to determine status of line and to obtain maintenance and inspection records to confirm integrity of line through the levee. LS marker visible, but no WS marker. The UCIP inspection was completed with GEI staff, P. Espinoza. (H. Dunn ? GEI)7/20/2016 Marker visible on LS. WS marker missing. (O. Magana - DWR UCIP)4/01/2014 Need to contact owner to confirm and obtain status of crossing. Markers misleading--unable to confirm if markers correspond to this crossing. Need markers at levee. (W. Wylie) FIELD_STRUCT_DESC: 30-inch coated steel natural gas pipeline through the levee, approximately 60 feet below the crown. Gas line markers are visible on the waterside (WS) and the landside (LS). (30-inch horizontal directional bore (HDD) authorized under Permit No. 18568, 2010 - Gill Ranch Storage, LLC). FS Date: 7/19/2021

Levee crown.

LS view: Toe from crown, marker way off in distance.

LS view: Closeup of marker with contact information.

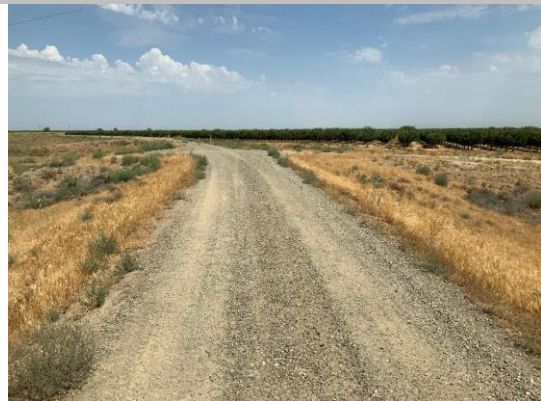
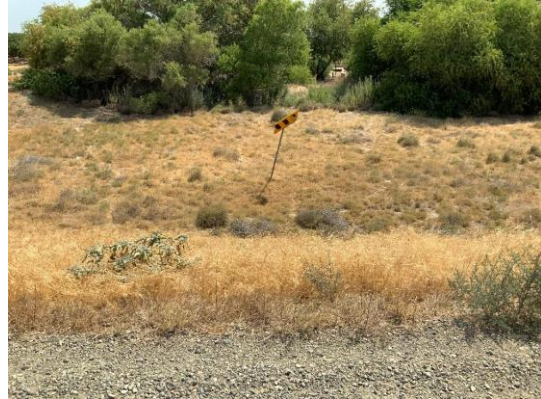
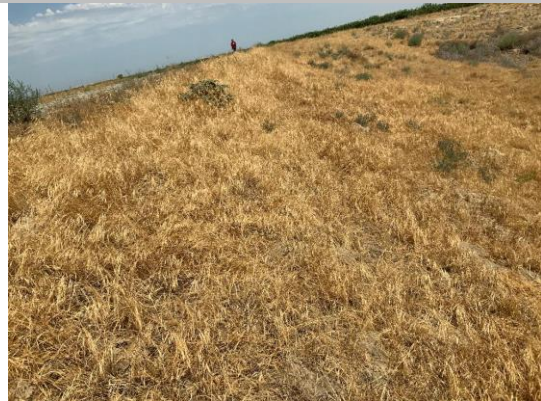
Photo 1 of 3 : UCIP_SP_2022_68524_102464.jpg

FS_ID:68524
 DS_ID:19919
 EP_NO: 15399
 Repair Type: Non-Urgent
 Crossing Status: Indicator Found
 UCIP Comments: 07/19/2021 The record has been upgraded from No Action Needed to Non-Urgent. As a safety measure, need to coordinate with owner to determine status of line and to obtain maintenance and inspection records to confirm integrity of line through the levee. The UCIP inspection was completed with GEI staff, P. Espinoza. (H. Dunn ? GEI)
 FIELD_STRUCT_DESC: 6-inch natural gas pipeline of an unknown material through the levee, 3 feet below the crown. Gas line markers at both toes. (Plans to install a 6-inch welded steel natural gas pipeline under the channel and within both levees of the San Joaquin River and the Chowchilla Bypass authorized under Permit No. 15399, 1990 - California Gas Gathering, Inc.). [Additional Reference(s): DWR Levee Log, 2002 (HLM 14.41), listed as a 6-inch gas line].

Levee crown.

LS view: Marker visible at toe from crown.

LS view: Slope from toe.

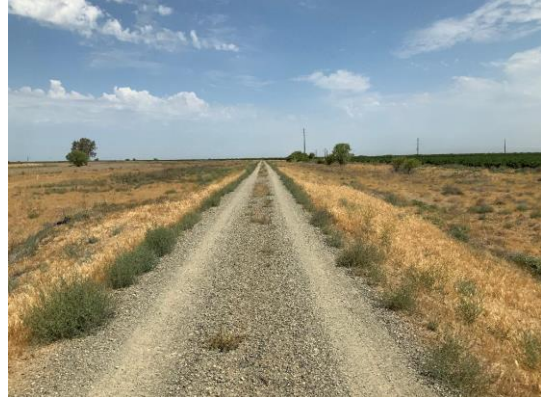
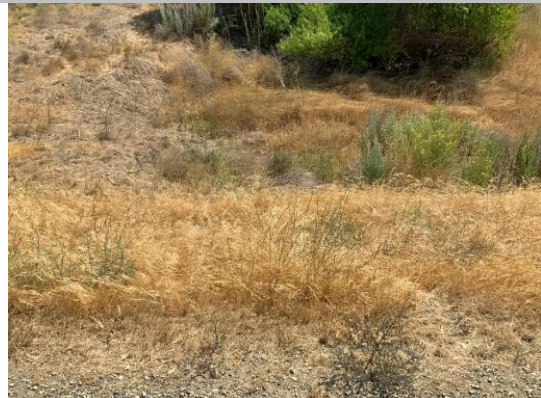
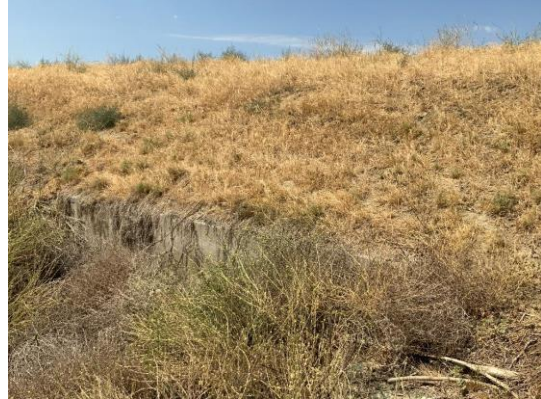
Photo 1 of 3 : UCIP_SP_2022_68525_102470.jpg

Comment Code					
Inspector Comment					
FS_ID:68525 DS_ID:19920 EP_NO: N/A Repair Type: Non-Urgent Crossing Status: Found UCIP Comments: 07/19/2021 The record remains Non-Urgent. Dense tumbleweeds over WS flapgate and LS inlet, recommend removal of both sides. Limited inspection on both WS and LS ends. No permit was found authorizing this encroachment. CVFPB will need to review crossing to determine owner. The UCIP inspection was completed with GEI staff, P. Espinoza. (H. Dunn ? GEI) 04/01/2014 Heavy vegetation buildup at LS toe--recommend clearing. (W. Wylie - DWR UCIP) FIELD_STRUCT_DESC: 30-inch by 30-inch square reinforced concrete box gravity drainage culvert through the levee, 14 feet below the crown. Flap gate on the waterside (WS) end. Concrete headwall on the landside (LS) end. Concrete U-shaped headwall on the WS end. [Additional Reference(s): DWR Levee Log, 2002 (HLM 14.70), listed as a 30-inch square reinforced concrete box culvert (RCBC). USACE San Joaquin O&M Manual, Unit 601 Part 1 (SJR601.1), 1967, (HLM 14.69), listed as a 2.5-feet by 2.5-feet RCBC]. FS Date: 7/19/2021

Levee crown.

LS view: Toe from crown.

LS view: Slope from toe.

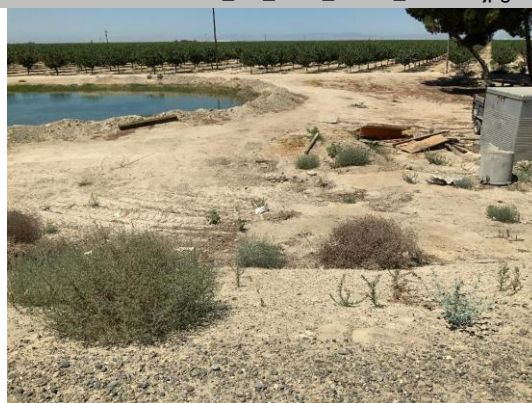
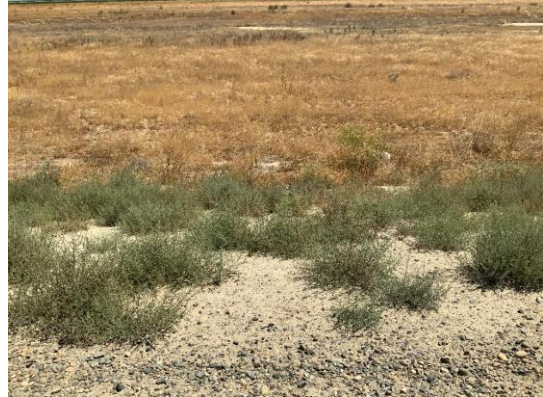
Photo 1 of 3 : UCIP_SP_2022_68890_102059.jpg

Comment Code						
Inspector Comment						
FS_ID:68890 DS_ID:19923 EP_NO: N/A Repair Type: Non-Urgent Crossing Status: Not Found UCIP Comments: 07/20/2021 The record is Non-Urgent. Pipe not found by visual inspection. DWR DMP geophysical study did not confirm presence of pipe through levee. Record will remain in UCIP's inspection records until future Levee Improvement Project can confirm no crossing was found through the levee. No permit was found authorizing this encroachment. CVFPB will need to review crossing to determine owner. The UCIP inspection was completed with GEI staff, P. Espinoza. (H. Dunn ? GEI) FIELD_STRUCT_DESC: 8-inch corrugated metal gravity drainage pipe through the levee, 7 feet below the crown. Slide gate in a 36-inch corrugated metal pipe (CMP) riser on the waterside (WS) slope. Concrete headwall on the landside (LS) end. [Additional Reference(s): DWR Levee Log, 2002]. FS Date: 7/20/2021

Levee crown.

LS view: Toe from crown, no pipe visible.

WS view: Toe from crown, no pipe visible.

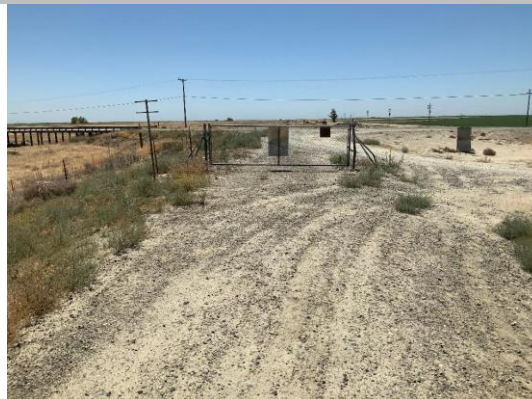
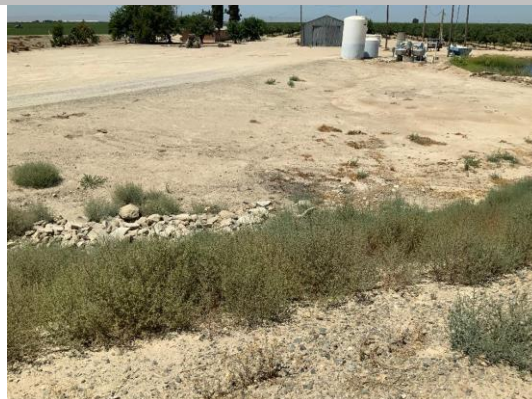
Photo 1 of 3 : UCIP_SP_2022_68244_102063.jpg

Comment Code						
Inspector Comment						
FS_ID:68244 DS_ID:19924 EP_NO: 11615 Repair Type: Non-Urgent Crossing Status: Not Found UCIP Comments: 07/20/2021 The record is Non-Urgent. Pipe not found by visual inspection. Confirm with owner on the status of this pipe. The UCIP inspection was completed with GEI staff, P. Espinoza. (H. Dunn ? GEI) FIELD_STRUCT_DESC: 1-inch polyvinyl chloride (PVC) water line through the levee, 0.333 feet below the crown. Water line extends from a cattle water trough at the landside (LS) toe. (Plans to install livestock watering troughs and a 1-inch water pipeline through the levee, at three locations on the left bank of the Chowchilla Bypass authorized under Permit No. 11615, 1976 - John M. Lasgoity). [Additional Reference(s): DWR Levee Log, 2002]. FS Date: 7/20/2021

Levee crown.

LS view: Toe from crown, no pipe visible.

WS view: Toe from crown, no pipe visible.

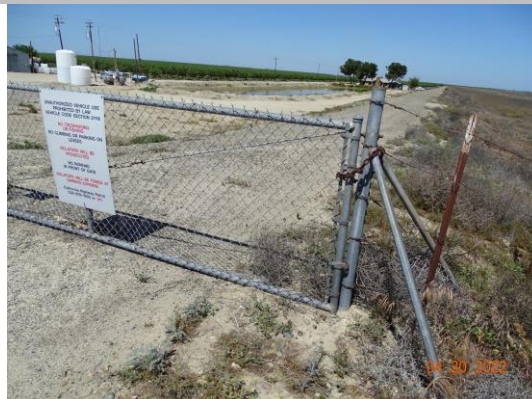
Photo 1 of 1 : SP_2022_NA0010_137_42_20220502_00059.jpg

LM Start	1.68	Rating **	U	Issue No.	42
LM End	1.68	Issue Type +	Ma	Location *	CR
Category	Earthen Levee			GPS Latitude/Longitude	
				Start	End
Item	Access Gates			36.952983 °	36.952983 °
				-120.351766 °	-120.351766 °
DWR ID	DWR_NA0010_18_s_2022_42				
Comment Code					
Inspector Comment					
Gate has broken off hinges and requires replacement.

View of broken hinges on the levee access gate. (Spring 2022)

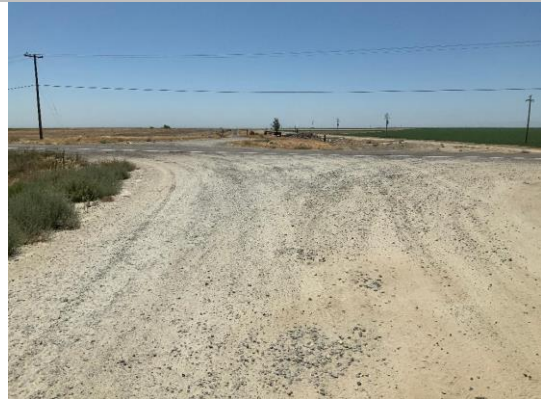
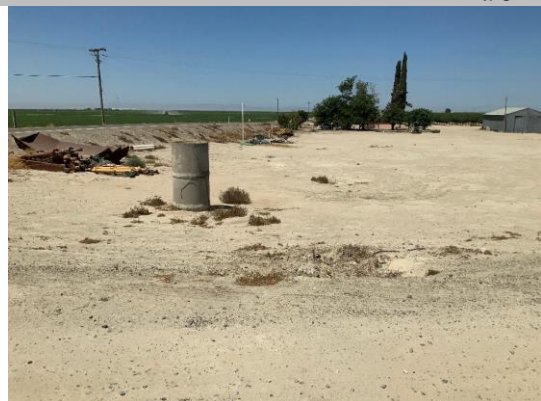
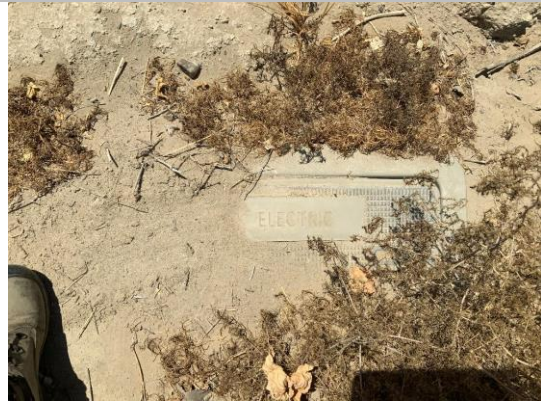
Photo 1 of 3 : UCIP_SP_2022_68245_102068.jpg

FS_ID:68245
DS_ID:19925
EP_NO: 6603
Repair Type: Non-Urgent
Crossing Status: Found
UCIP Comments: 07/20/2021 The record remains Non-Urgent. Flowmeter and pump on pipe appears newer, likely not abandoned as stated in previous inspection. Some erosion around the flowmeter on WS slope. The UCIP inspection was completed with GEI staff, P. Espinoza. (H. Dunn ? GEI) 04/10/2014 Need to contact owner. Appears abandoned--good candidate for video or pressure inspection. This crossings is the same age as the pipe that has failed immediately upstream. (DWR UCIP - O. Magana)
FIELD_STRUCT_DESC: 15-inch steel irrigation discharge pipe through the levee, 4.3 feet below the crown. Electrical conduit of an unknown size or material through the levee, 4.3 feet below the crown. Siphon breaker on the landside (LS) shoulder. 36-inch concrete standpipe on the LS berm. Inlet facility on the waterside (WS) bank consisting of a pump, a 42-inch concrete standpipe, and a 20-inch concrete channel with an intake pipe and a cutoff wall. (Plans to install a pump and outlet pipe at two locations on the left bank levee of the Chowchilla Bypass authorized under Permit No. 6603, 1969 - Raymond N. Costales).

Levee crown.

LS view: Toe from crown, riser visible.

LS view: Electrical manhole off toe.

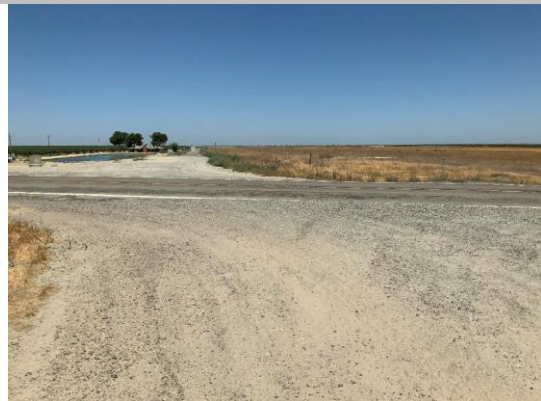
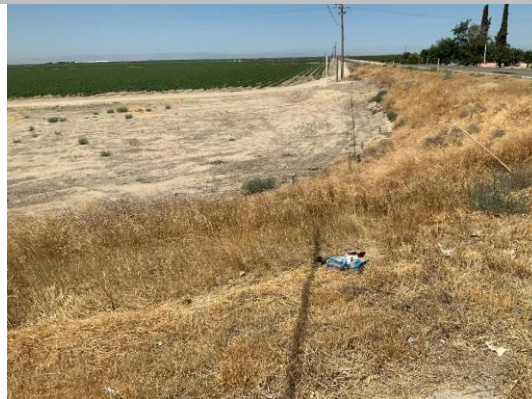
Photo 1 of 3 : UCIP_SP_2022_68246_102072.jpg

FS_ID:68246
DS_ID:19681
EP_NO: 5837
Repair Type: Non-Urgent
Crossing Status: Not Found
UCIP Comments: 07/20/2021 The record is Non-Urgent. Pipe not found by visual inspection. Confirm with owner on the status of this pipe. The UCIP inspection was completed with GEI staff, P. Espinoza. (H. Dunn ? GEI)
FIELD_STRUCT_DESC: 1 of 2: 15-inch steel drainage discharge pipe through the levee, 2 feet below the crown. Channel inlet pipe and pump on the waterside (WS). Screw gate on WS with catwalk to access gate and pump. 20-inch irrigation pipe and standpipe on the landside (LS). (Plans for construction of two irrigation structures through the left bank levee of the Chowchilla Bypass authorized under Permit No. 5837, 1967 - Raymond N. Costales).
FS Date: 7/20/2021

Levee crown.

LS view: Toe from crown, no pipe visible.

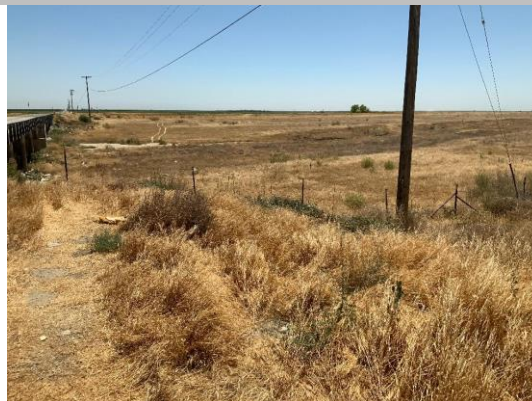
Photo 3 of 3 : UCIP_SP_2022_68246_102074.jpg

WS view: Toe from crown, no pipe visible.

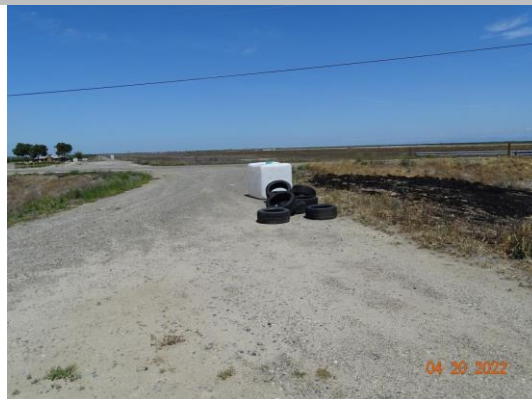
Photo 1 of 1 : SP_2022_NA0010_137_41_20220502_00060.jpg

LM Start	1.73	Rating **	M	Issue No.	41
LM End	1.73	Issue Type +	En	Location *	CR
Category	Earthen Levee			GPS Latitude/Longitude	
				Start	End
Item	Encroachments			36.952303 °	36.952303 °
				-120.351328 °	-120.351328 °
DWR ID	DWR_NA0010_18_s_2022_41				
Comment Code					
GA : Garbage					
Inspector Comment

Trash left on the levee crown near Avenue 14 crossing. (Spring 2022)

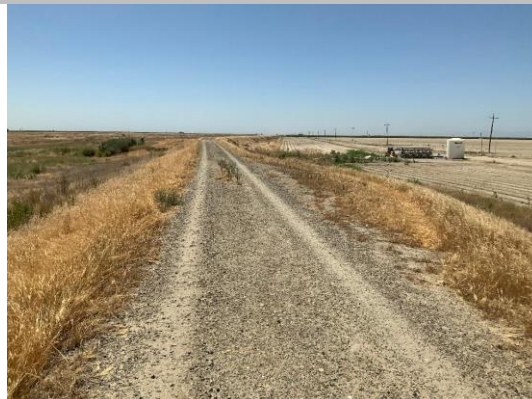
Photo 1 of 3 : UCIP_SP_2022_68247_102075.jpg

Levee crown.

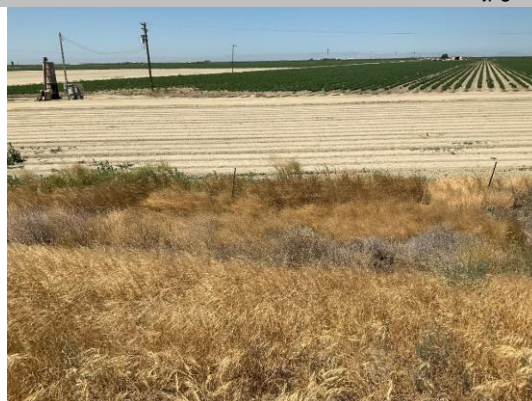
Photo 2 of 3 : UCIP_SP_2022_68247_102077.jpg

LS view: Toe from crown, no pipe visible.

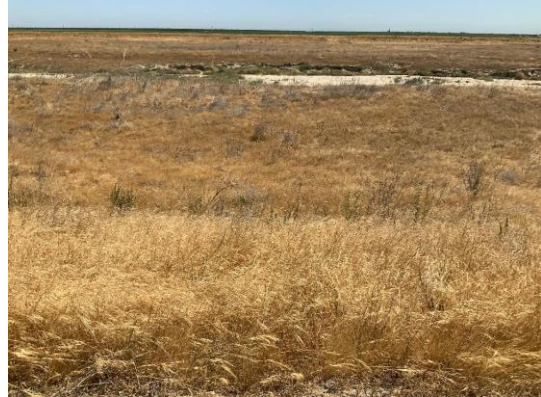
Photo 3 of 3 : UCIP_SP_2022_68247_102076.jpg

WS view: Toe from crown, no pipe visible.

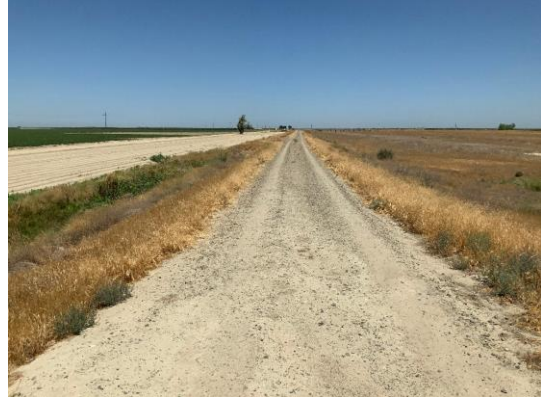
Photo 1 of 3 : UCIP_SP_2022_68891_102078.jpg

Levee crown.

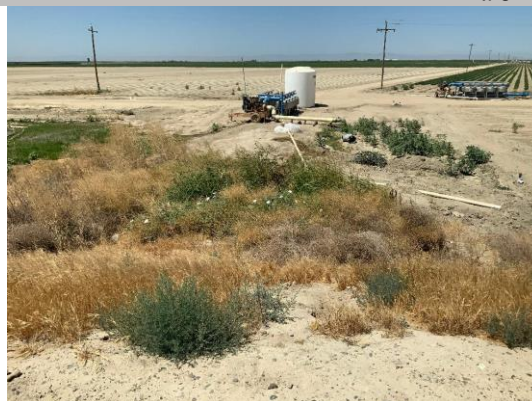
Photo 2 of 3 : UCIP_SP_2022_68891_102081.jpg

LS view: Toe from crown.

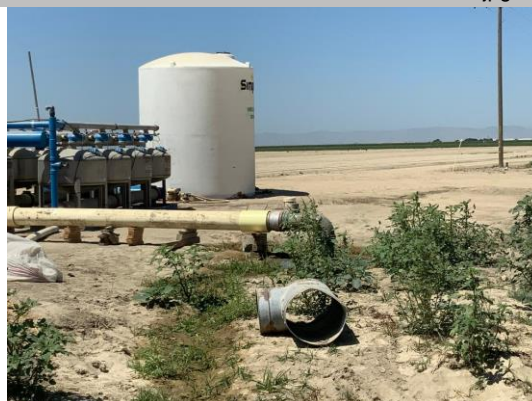
Photo 3 of 3 : UCIP_SP_2022_68891_102082.jpg

LS view: Closeup of new filtration system and pipe located landward of the levee toe.

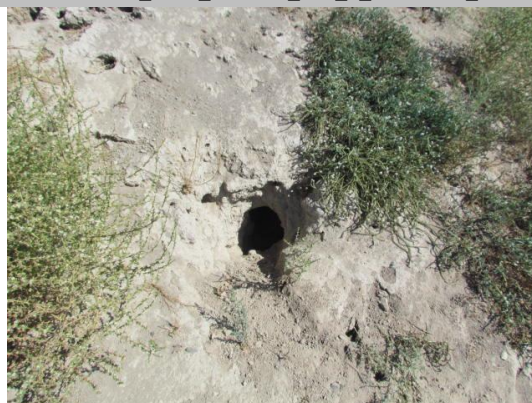
Photo 1 of 1 : SP_2022_NA0010_137_8_20220308_00002.jpg

LM Start	2.25	Rating **	U	Issue No.	8
LM End	2.25	Issue Type +	Ma	Location *	LS
Category	Earthen Levee			GPS Latitude/Longitude	
				Start	End
Item	Animal Control			36.945563 °	36.945563 °
				-120.347121 °	-120.347121 °
DWR ID	DWR_NA0010_18_f_2015_8				
Comment Code					
A3 : No rodents visible, but rodent burrows visible; need to backfill and compact or grout burrows.					
Inspector Comment					
There is one large rodent hole and other smaller rodent holes within this area.

Looking at large rodent hole on landward slope.

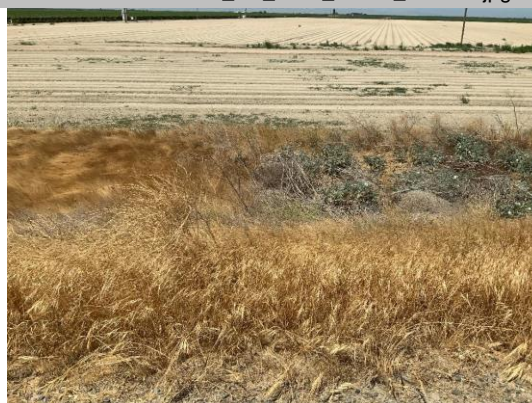
Photo 2 of 3 : UCIP_SP_2022_68249_102086.jpg

LS view: Toe from crown, no pipe visible.

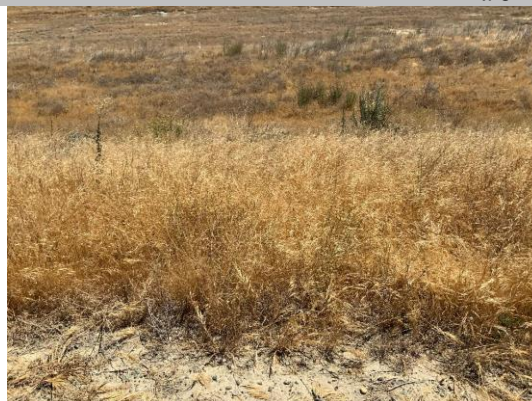
Photo 3 of 3 : UCIP_SP_2022_68249_102085.jpg

WS view: Toe from crown, no pipe visible.

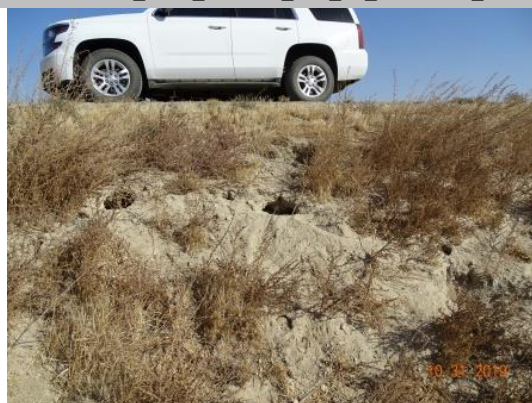
Photo 1 of 1 : SP_2022_NA0010_137_31_20220308_00009.jpg

LM Start	3.41	Rating **	U	Issue No.	31
LM End	3.44	Issue Type +	Ma	Location *	LS
Category	Earthen Levee			GPS Latitude/Longitude	
				Start	End
Item	Animal Control			36.929498 °	36.929093 °
				-120.341091 °	-120.340920 °
DWR ID	DWR_NA0010_18_f_2019_31				
Comment Code					
A3 : No rodents visible, but rodent burrows visible; need to backfill and compact or grout burrows.					
Inspector Comment

View of rodent burrows in the landside slope. (Fall 2019)

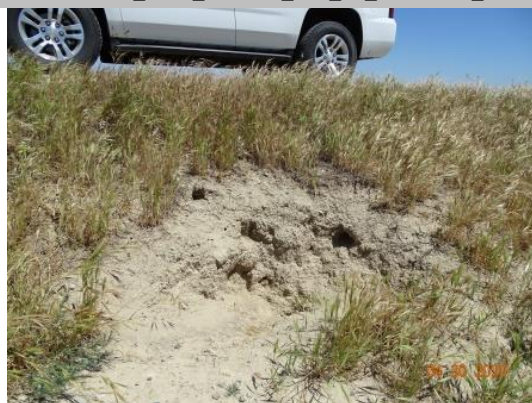
Photo 1 of 1 : SP_2022_NA0010_137_47_20220308_00015.jpg

LM Start	3.73	Rating **	U	Issue No.	47
LM End	3.73	Issue Type +	Ma	Location *	LS
Category	Earthen Levee			GPS Latitude/Longitude	
				Start	End
Item	Animal Control			36.924969 °	36.924969 °
				-120.339407 °	-120.339407 °
DWR ID	DWR_NA0010_18_s_2020_47				
Comment Code					
A3 : No rodents visible, but rodent burrows visible; need to backfill and compact or grout burrows.					
Inspector Comment

Large rodent burrow in the landside slope. (Spring 2020)

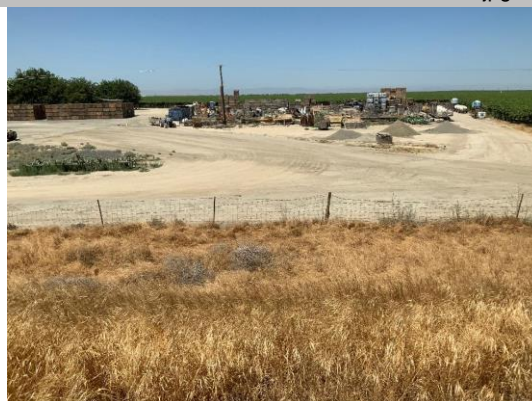
Photo 2 of 3 : UCIP_SP_2022_68250_102088.jpg

LS view: Toe from crown, no pipe visible.

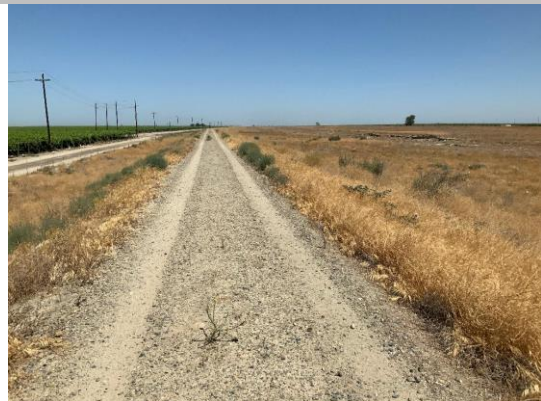
Photo 1 of 3 : UCIP_SP_2022_68251_102090.jpg

Levee crown.

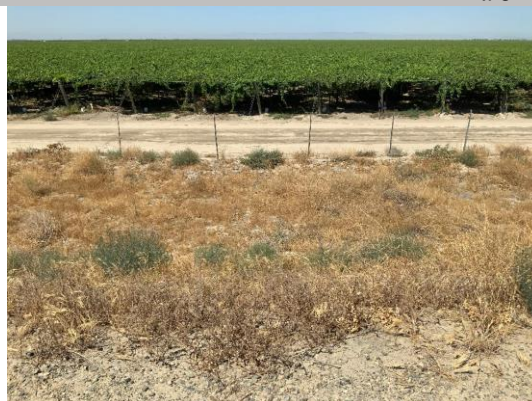
Photo 2 of 3 : UCIP_SP_2022_68251_102091.jpg

LS view: Toe from crown, no pipe visible.

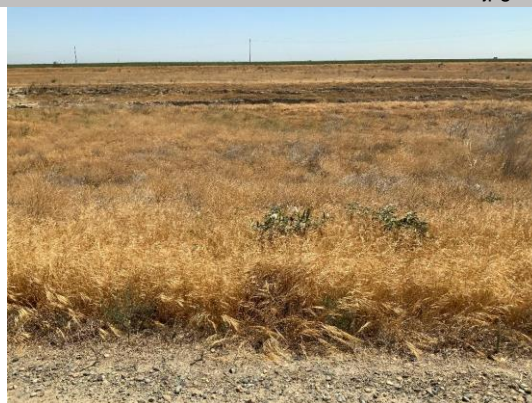
Photo 3 of 3 : UCIP_SP_2022_68251_102092.jpg

WS view: Toe from crown, no pipe visible.

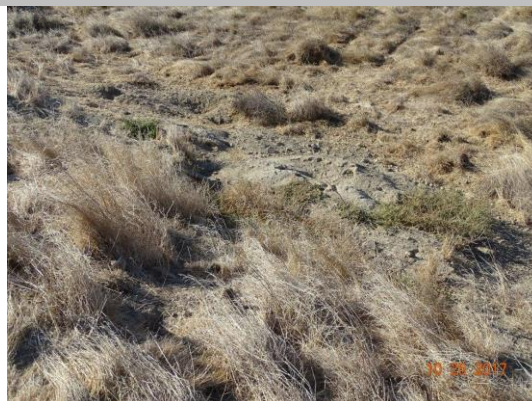
Photo 1 of 1 : SP_2022_NA0010_137_15_20220308_00005.jpg

LM Start	5.74	Rating **	U	Issue No.	15
LM End	5.99	Issue Type +	Ma	Location *	LS
Category	Earthen Levee			GPS Latitude/Longitude	
				Start	End
Item	Animal Control			36.897237 °	36.893924 °
				-120.328633 °	-120.327020 °
DWR ID	DWR_NA0010_18_f _ 2017_15				
Comment Code					
A3 : No rodents visible, but rodent burrows visible; need to backfill and compact or grout burrows.					
Inspector Comment					
There are multiple large rodent holes at the landside toe.

Looking west at the landside slope. (Fall 2017)

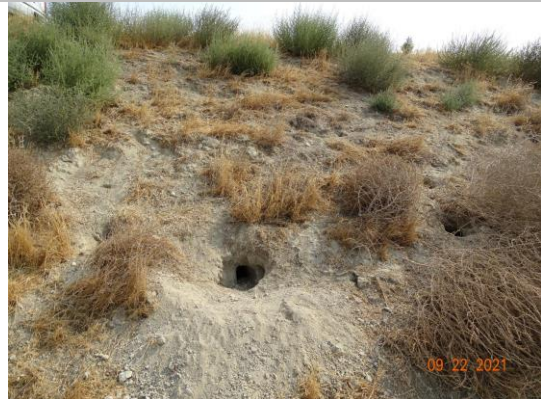
Photo 1 of 1 : SP_2022_NA0010_137_35_20220308_00012.jpg

LM Start	6.62	Rating **	M	Issue No.	35
LM End	6.62	Issue Type +	Ma	Location *	LS
Category	Earthen Levee			GPS Latitude/Longitude	
				Start	End
Item	Animal Control			36.885376 °	36.885376 °
				-120.322820 °	-120.322820 °
DWR ID	DWR_NA0010_18_f_2021_35				
Comment Code					
A3 : No rodents visible, but rodent burrows visible; need to backfill and compact or grout burrows.					
Inspector Comment

Looking at rodent holes on the landside slope. (Fall 2021)

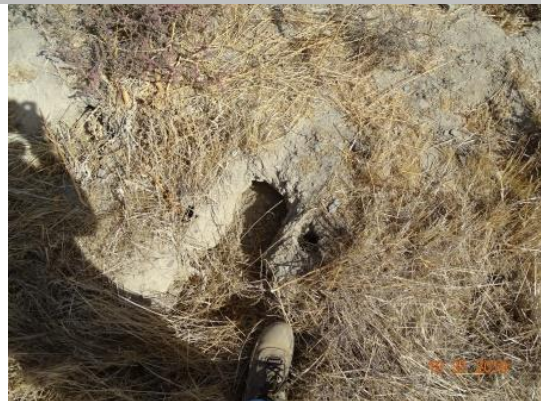
Photo 1 of 1 : SP_2022_NA0010_137_23_20220308_00008.jpg

LM Start	6.84	Rating **	U	Issue No.	23
LM End	6.84	Issue Type +	Ma	Location *	LS
Category	Earthen Levee			GPS Latitude/Longitude	
				Start	End
Item	Animal Control			36.882384 °	36.882384 °
				-120.321417 °	-120.321417 °
DWR ID	DWR_NA0010_18_f _ 2019_23				
Comment Code					
A1 : Exterminate rodents and backfill and compact or grout burrows.					
Inspector Comment

Representative view of rodent burrows observed at this location. (Fall 2019)

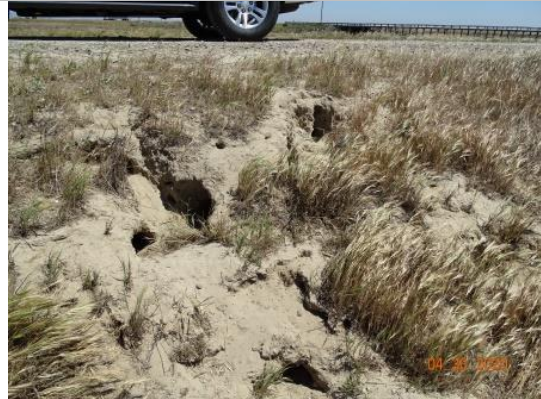
Photo 1 of 1 : SP_2022_NA0010_137_14_20220308_00004.jpg

LM Start	7.39	Rating **	U	Issue No.	14
LM End	7.53	Issue Type +	Ma	Location *	LS
Category	Earthen Levee			GPS Latitude/Longitude	
				Start	End
Item	Animal Control			36.874479 °	36.872503 °
				-120.319831 °	-120.319438 °
DWR ID	DWR_NA0010_18_f_2017_14				
Comment Code					
A3 : No rodents visible, but rodent burrows visible; need to backfill and compact or grout burrows.					
Inspector Comment					
There are several rodent holes noted along the landside slope in this area.

View of rodent burrows in the landside slope. (Spring 2020)
