**Flood Control Project Maintenance
Levee Inspections
LMA District Cover Sheet**

Lower San Joaquin Levee District

**Flood Control Project Maintenance
Levee Inspections
Unit Cover Sheet**

Levee Inspection Report By Mile - Spring 2022

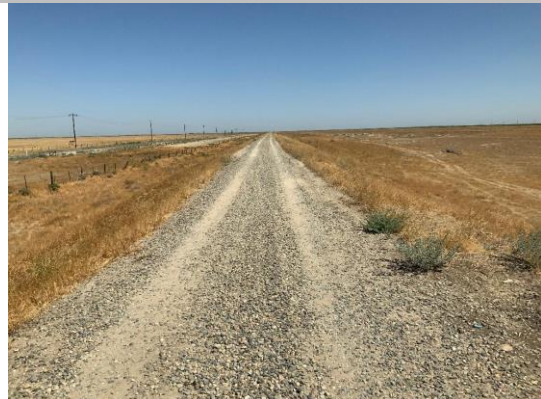
Photo 1 of 3 : UCIP_SP_2022_68892_102097.jpg

Comment Code					
Inspector Comment					
FS_ID:68892 DS_ID:19930 EP_NO: 13548 Repair Type: Non-Urgent Crossing Status: Found UCIP Comments: 07/20/2021 The record remains Non-Urgent. No longer debris or sediment inside LS pipe outlet. WS pipe does not appear to be distorted, but has minor vegetation over inlet, recommend removal. The UCIP inspection was completed with GEI staff, P. Espinoza. (H. Dunn ? GEI) 04/10/2014 CMP crossing is distorted on waterward side. Debris scattered on landward side. Sediment deposit inside crossing visible from landward side. Recommend removing debris from landward side. (DWR UCIP - O. Magana) FIELD_STRUCT_DESC: 42-inch reinforced concrete gravity irrigation pipe through the levee, 19 feet below the crown. Gate structure on the waterside (WS) shoulder. Pipe section on the WS is corrugated metal. Pipe section on the landside (LS) is reinforced concrete. (Plans to install a 42-inch gravity-flow concrete pipeline through the left bank levee of the Eastside Bypass to divert bypass waters for irrigation purposes authorized under Permit No. 13548, 1983 - New Stone Water District). [Additional Reference(s): DWR Levee Log, 2002]. FS Date: 7/30/2021 3:01:27 PM

Levee crown.

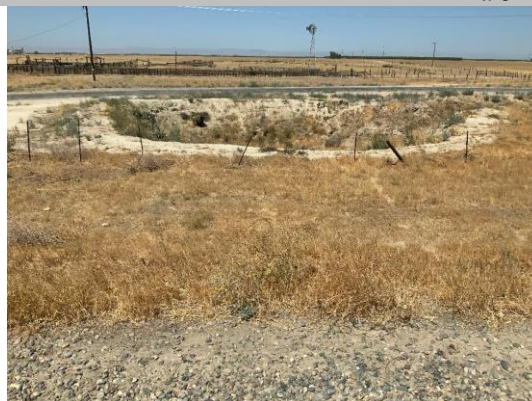
Photo 2 of 3 : UCIP_SP_2022_68892_102098.jpg

LS view: Toe from crown.

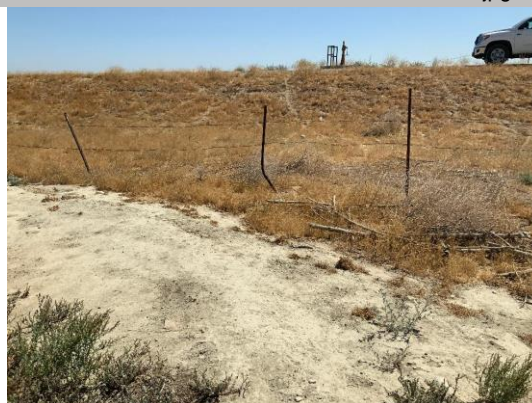
Photo 3 of 3 : UCIP_SP_2022_68892_102099.jpg

LS view: Slope from toe.

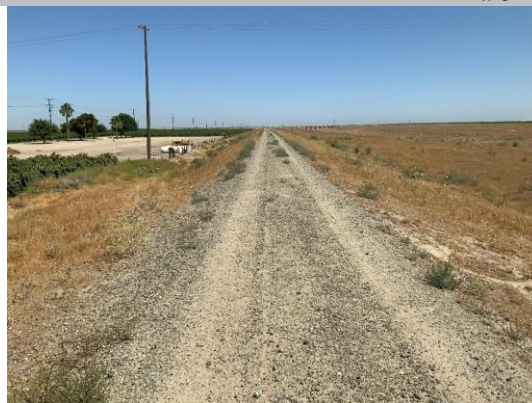
Photo 1 of 3 : UCIP_SP_2022_68253_102101.jpg

Comment Code						
Inspector Comment						
FS_ID:68253 DS_ID:19931 EP_NO: 11615 Repair Type: Non-Urgent Crossing Status: Not Found UCIP Comments: 07/20/2021 The record is Non-Urgent. Pipe not found by visual inspection. Confirm with owner on the status of this pipe. The UCIP inspection was completed with GEI staff, P. Espinoza. (H. Dunn ? GEI) FIELD_STRUCT_DESC: 1-inch polyvinyl chloride (PVC) water line through the levee, 2 feet below the crown. Water line extends from a cattle water trough at the landside (LS) toe. (Plans to install livestock watering troughs and a 1-inch water pipeline through the levee, at three locations on the left bank of the Chowchilla Bypass authorized under Permit No. 11615, 1976 - John M. Lasgoity). [Additional Reference(s): DWR Levee Log, 2002]. FS Date: 7/20/2021

Levee crown.

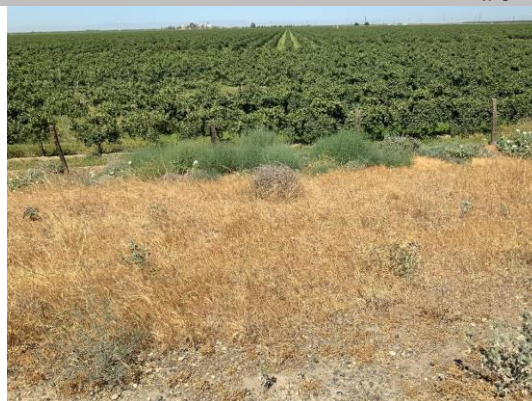
Photo 2 of 3 : UCIP_SP_2022_68253_102102.jpg

LS view: Toe from crown, no pipe visible.

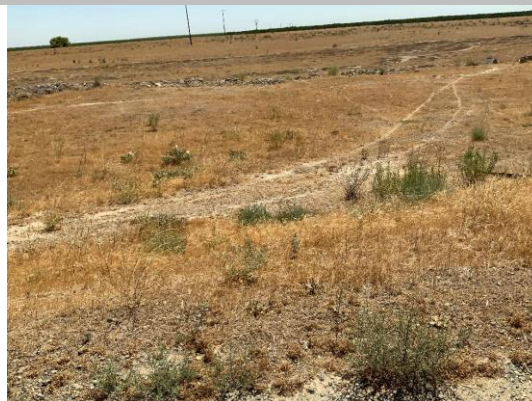
Photo 3 of 3 : UCIP_SP_2022_68253_102103.jpg

WS view: Toe from crown, no pipe visible.

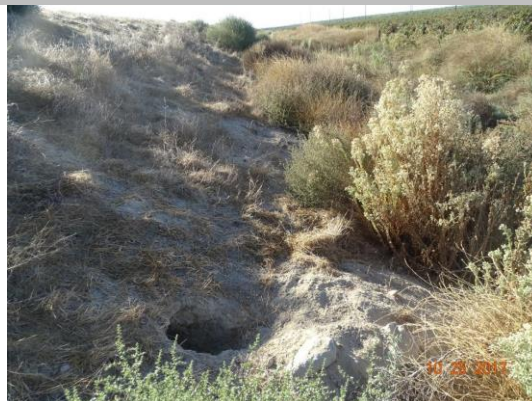
Photo 1 of 1 : SP_2022_NA0010_137_13_20220308_00003.jpg

LM Start	8.67	Rating **	U	Issue No.	13
LM End	8.67	Issue Type +	Ma	Location *	LS
Category	Earthen Levee			GPS Latitude/Longitude	
				Start	End
Item	Animal Control			36.856115 °	36.856115 °
				-120.316595 °	-120.316595 °
DWR ID	DWR_NA0010_18_f_2017_13				
Comment Code					
A3 : No rodents visible, but rodent burrows visible; need to backfill and compact or grout burrows.					
Inspector Comment

Looking south at the landside slope.

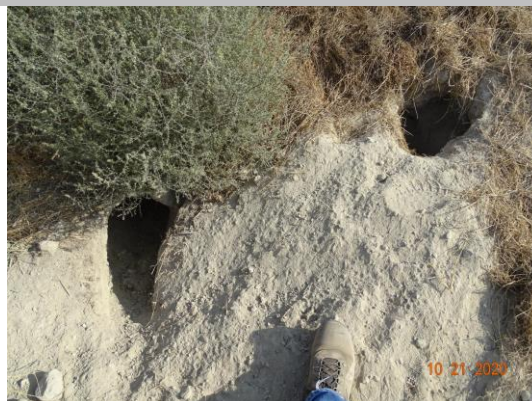
Photo 1 of 1 : SP_2022_NA0010_137_18_20220308_00006.jpg

LM Start	8.89	Rating **	U	Issue No.	18
LM End	8.89	Issue Type +	Ma	Location *	LS
Category	Earthen Levee			GPS Latitude/Longitude	
				Start	End
Item	Animal Control			36.852936 °	36.852936 °
				-120.316451 °	-120.316451 °
DWR ID	DWR_NA0010_18_f_2020_18				
Comment Code					
A3 : No rodents visible, but rodent burrows visible; need to backfill and compact or grout burrows.					
Inspector Comment

Large rodent holes in the landside slope. (Fall 2020)

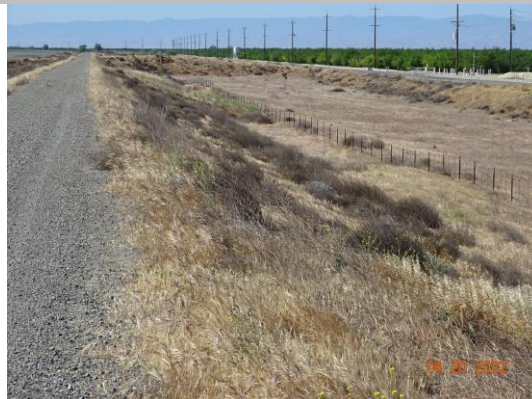
Photo 1 of 1 : SP_2022_NA0010_137_33_20220502_00061.jpg

LM Start	10.97	Rating **	M	Issue No.	33
LM End	12.21	Issue Type +	Ma	Location *	LS
Category	Earthen Levee			GPS Latitude/Longitude	
				Start	End
Item	Vegetation			36.827901 °	36.810895 °
				-120.300125 °	-120.307029 °
DWR ID	DWR_NA0010_18_s_2022_33				
Comment Code					
V1 : Control annual grass and weeds on the levee slopes and easements.					
Inspector Comment

Looking upstream along the landside slope. (Spring 2022)

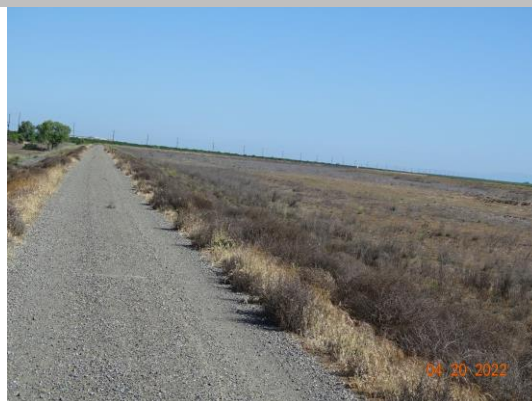
Photo 1 of 1 : SP_2022_NA0010_137_32_20220502_00062.jpg

LM Start	13.03	Rating **	M	Issue No.	32
LM End	13.24	Issue Type +	Ma	Location *	WS
Category	Earthen Levee			GPS Latitude/Longitude	
				Start	End
Item	Vegetation			36.799306 °	36.796389 °
				-120.308828 °	-120.308388 °
DWR ID	DWR_NA0010_18_s_2022_32				
Comment Code					
V1 : Control annual grass and weeds on the levee slopes and easements.					
Inspector Comment

View of vegetation on the waterside slope looking downstream. (Spring 2022)

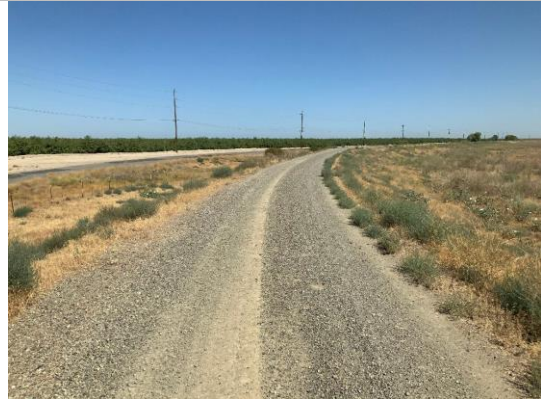
Photo 1 of 3 : UCIP_SP_2022_68893_102105.jpg

Comment Code						
Inspector Comment						
FS_ID:68893 DS_ID:19569 EP_NO: 13049 Repair Type: Non-Urgent Crossing Status: Found UCIP Comments: 07/20/2021 The record has been upgraded from No Action Needed to Non-Urgent. LS pipe inlet is across the road and behind barbed wire, could not access, limited inspection. WS pipe outlet has sediment buildup inside, recommend removal. The UCIP inspection was completed with GEI staff, P. Espinoza. (H. Dunn ? GEI) FIELD_STRUCT_DESC: 36-inch reinforced concrete gravity drainage pipe through the levee, 14.8 feet below the crown. Gate structure on the waterside (WS) slope. Standpipe on the WS end. Riprap on the landside (LS) slope. (Plans to install a 36-inch reinforced concrete pipe through the levee authorized under Permit No. 13049, 1981 - Newhall Land and Farming Company). [Additional Reference(s): DWR Levee Log, 2002]. FS Date: 7/20/2021

Levee crown.

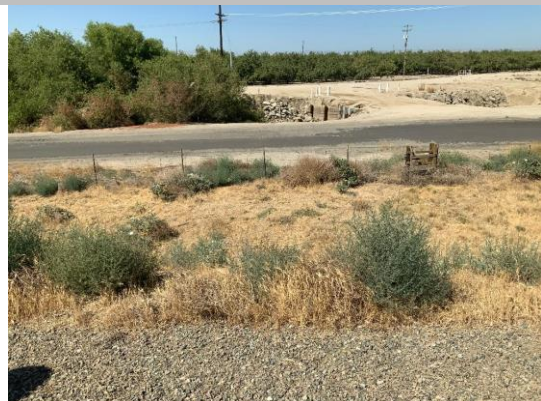
Photo 2 of 3 : UCIP_SP_2022_68893_102106.jpg

LS view: Toe from crown.

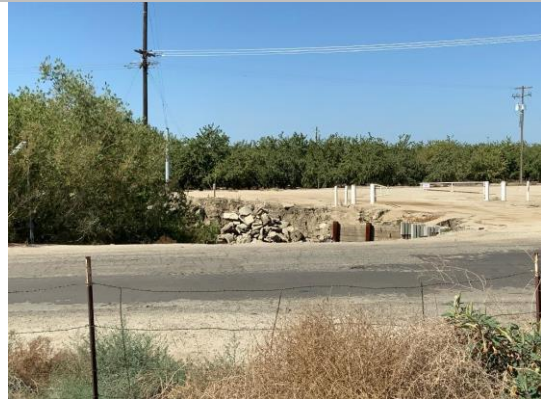
Photo 3 of 3 : UCIP_SP_2022_68893_102107.jpg

LS view: Pipe inlet across road and behind barbed wire.

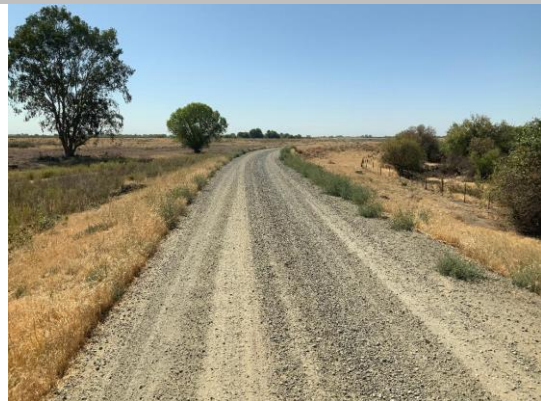
Photo 1 of 3 : UCIP_SP_2022_68255_102113.jpg

FS_ID:68255
DS_ID:19932
EP_NO: N/A
Repair Type: Non-Urgent
Crossing Status: Indicator Found
UCIP Comments: 07/20/2021 The record remains Non-Urgent. As previous inspection stated, contact owner to confirm alignment. Markers are visible on LS and WS but the way they are facing makes it appear that the line is going parallel to the levee and not through it. No permit was found authorizing this encroachment. CVFPB will need to review crossing to determine owner. The UCIP inspection was completed with GEI staff, P. Espinoza. (H. Dunn ? GEI) 04/08/2014 Multiple markers visible along waterward and landward sides unable to confirm how many crossings go through levee. Need to contact owner to obtain additional details on crossings. (DWR UCIP - O. Magana) FIELD_STRUCT_DESC: 6-inch natural gas pipeline of an unknown material through the levee. Pipeline extends underneath the channel. [Additional Reference(s): DWR Levee Log, 2002].

Levee crown.

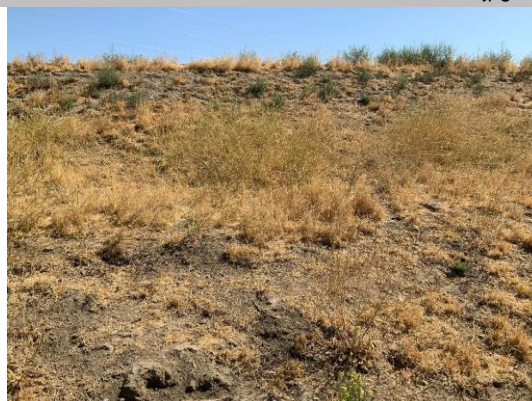
Photo 3 of 3 : UCIP_SP_2022_68255_102112.jpg

LS view: Slope from toe.

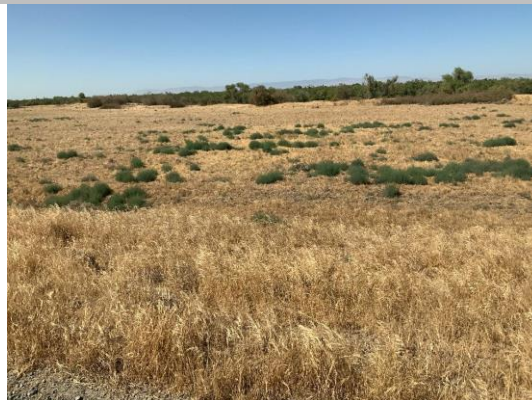
Photo 2 of 3 : UCIP_SP_2022_68256_102119.jpg

Comment Code					
Inspector Comment					
FS_ID:68256 DS_ID:19682 EP_NO: 6187 Repair Type: Non-Urgent Crossing Status: Not Found UCIP Comments: 07/20/2021 The record is Non-Urgent. Pipe not found by visual inspection. Confirm with owner on the status of this pipe. The UCIP inspection was completed with GEI staff, P. Espinoza. (H. Dunn ? GEI) FIELD_STRUCT_DESC: 18-inch irrigation discharge pipe of an unknown material on the levee crown, placed in a mound fill, 2 feet deep. Pump on the riverbank. (Plans for installation of a pump on the riverbank and installation of a discharge pipe over the levee authorized under Permit No. 6187, 1967 - Newhall Land and Farming Company). FS Date: 7/20/2021

LS view: Toe from crown, no pipe visible.

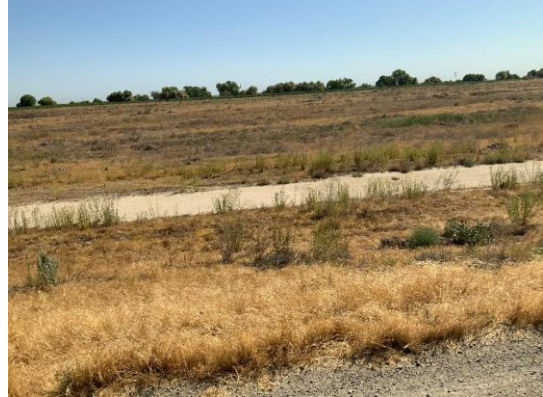
Photo 3 of 3 : UCIP_SP_2022_68256_102118.jpg

WS view: Toe from crown, no pipe visible.

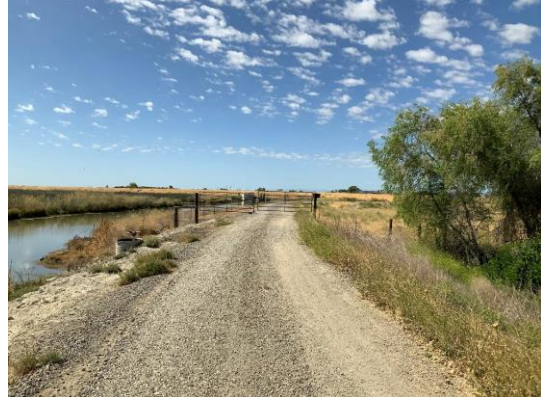
Photo 1 of 3 : UCIP_SP_2022_69879_103853.jpg

FS_ID:69879
DS_ID:19933
EP_NO: N/A
Repair Type: Non-Urgent
Crossing Status: Found
UCIP Comments: 06/09/2021 The record remains Non-Urgent. Limited inspection of LS due to dense vegetation; recommend removal. Limited inspection on WS due to elevated water level. No pipe inlet or outlet was visible on LS or WS. Riser on WS missing lid, causing a safety hazard. No permit was found authorizing this encroachment. CVFPB will need to review crossing to determine owner. The UCIP inspection was completed with GEI staff, H.Dunn. (P.Espinoza ? GEI)

07/19/2016 Gate inside riser appears operable--riser lid damage. Crossing is not visible on LS due to dense vegetation. Recommend clearing dense vegetation along WS and LS slope and repairing riser cover. (O. Magana - DWR UCIP)04/15/2014 No actuator wheel on slide gate at WS shoulder. (W. Wylie - DWR UCIP)
FIELD_STRUCT_DESC: 24-inch corrugated metal gravity drainage pipe through the levee, 14.8 feet below the crown. Slide gate in a 36-inch corrugated metal pipe (CMP) riser on the waterside (WS) slope. Concrete U-shaped headwall on each end. [Additional Reference(s): DWR Levee Log, 2002 (HLM 0.10), listed as a 24-inch corrugated metal pipe (CMP). USACE San Joaquin O&M Manual, Unit 601 Part 1 (SJR601.1), 1967, Revised 25 May 2011, (HLM 0.10), listed as a 24-inch CMP].
FS Date: 6/9/2021 12:38:00 PM

View from levee crown. CMP riser visible on WS.

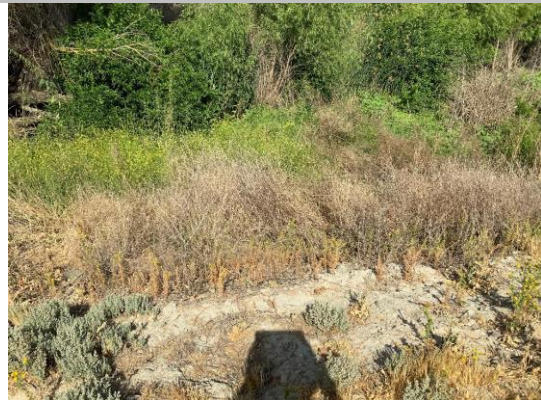
Photo 2 of 3 : UCIP_SP_2022_69879_103856.jpg

LS view: Toe from crown, dense vegetation.

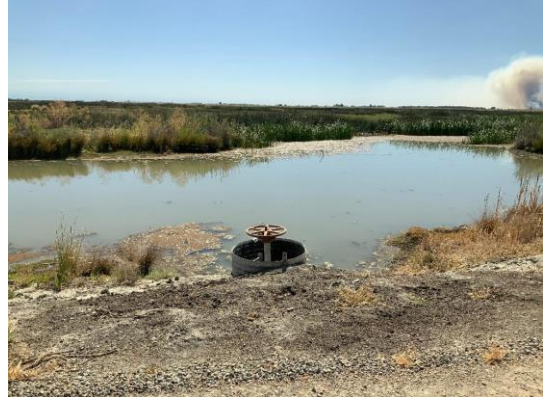
Photo 3 of 3 : UCIP_SP_2022_69879_103854.jpg

WS view: Slope from crown, CMP riser visible at toe.

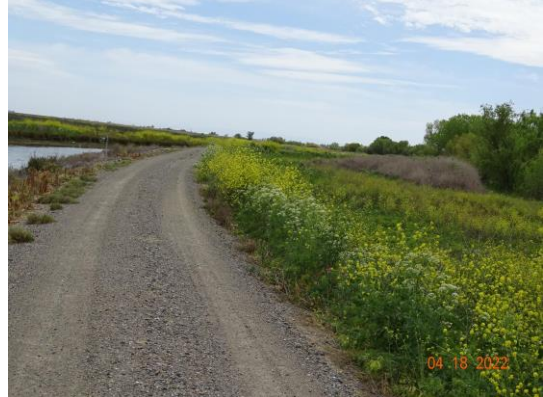
Photo 1 of 1 : SP_2022_NA0010_138_38_20220502_00060.jpg

LM Start	0.50	Rating **	U	Issue No.	38
LM End	0.89	Issue Type +	Ma	Location *	LS
Category	Earthen Levee			GPS Latitude/Longitude	
				Start	End
Item	Vegetation			37.212601 °	37.218166 °
				-120.697992 °	-120.697531 °
DWR ID	DWR_NA0010_22A_s_2022_38				
Comment Code					
V1 : Control annual grass and weeds on the levee slopes and easements.					
Inspector Comment

View of the vegetation growing on the landside slope. (Spring 2022)

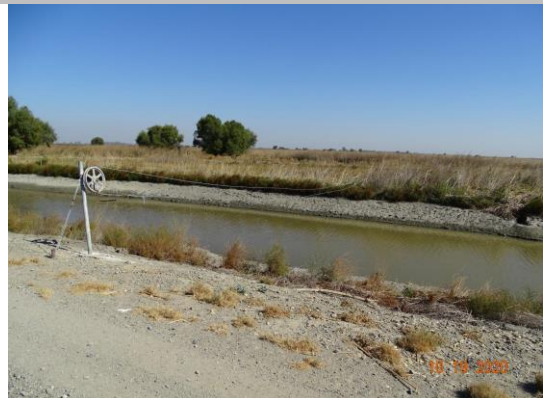
Photo 1 of 1 : SP_2022_NA0010_138_23_20220308_00021.jpg

LM Start	0.87	Rating **	M	Issue No.	23
LM End	0.87	Issue Type +	En	Location *	WS
Category	Earthen Levee			GPS Latitude/Longitude	
				Start	End
Item	Encroachments			37.217802 °	37.217802 °
				-120.697416 °	-120.697416 °
DWR ID	DWR_NA0010_22A_f_2014_23				
Comment Code					
SI : Sign					
Inspector Comment					
A pulley is located on the waterside shoulder without a board permit.

Pulley on the waterside shoulder. (Fall 2020)

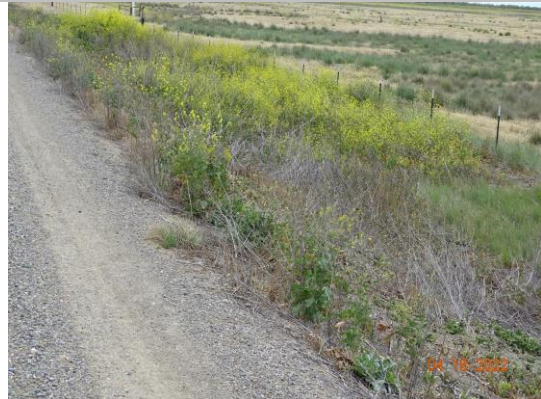
Photo 1 of 1 : SP_2022_NA0010_138_36_20220502_00061.jpg

LM Start	0.89	Rating **	M	Issue No.	36
LM End	1.58	Issue Type +	Ma	Location *	LS
Category	Earthen Levee			GPS Latitude/Longitude	
				Start	End
Item	Vegetation			37.218166 °	37.227678 °
				-120.697531 °	-120.700998 °
DWR ID	DWR_NA0010_22A_s_2022_36				
Comment Code					
V1 : Control annual grass and weeds on the levee slopes and easements.					
Inspector Comment

Looking upstream along the landside slope. (Spring 2022)

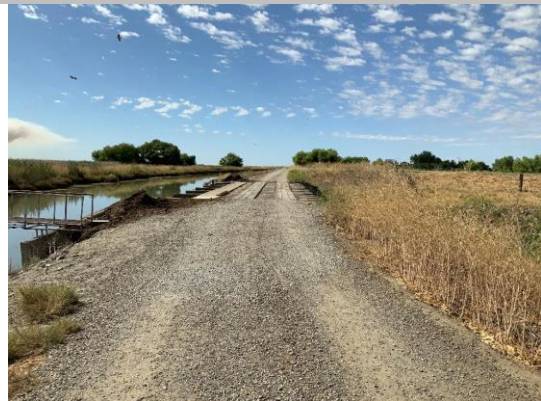
Photo 1 of 3 : UCIP_SP_2022_69772_103857.jpg

Comment Code						
Inspector Comment						
FS_ID:69772 DS_ID:19934 EP_NO: N/A Repair Type: Non-Urgent Crossing Status: Found UCIP Comments: 06/09/2021 The record has been upgraded from No Action Needed to Non-Urgent. Structure is functioning and in good standing. No permit was found authorizing this encroachment. CVFPB will need to review crossing to determine owner. The UCIP inspection was completed with GEI staff, H.Dunn. (P.Espinoza ? GEI) 10/27/2017 This structure is inspected annually under the Structure and Channel Summer Inspection (part of the Levee Inspection Program) conducted by the DWR Flood Project Integrity and Inspection Branch (FPIIB). (O. Magana - DWR UCIP) FIELD_STRUCT_DESC: [Owens Creek Irrigation Structure] 1 of 7: 96-inch by 168-inch reinforced concrete gravity irrigation opening. Metal slots on the waterside (WS) for wooden flashboards. Timber bridge across irrigation structure. [Additional Reference(s): DWR Levee Log, 2002 (HLM 1.00), listed as a seven 8-foot by 14-foot reinforced concrete structure, known as Owens Creek Structure]. FS Date: 6/9/2021 1:03:00 PM

View from levee crown.

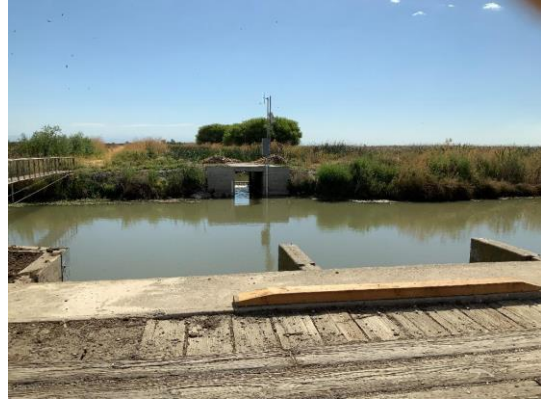
Photo 2 of 3 : UCIP_SP_2022_69772_103858.jpg

LS view: From timber bridge.

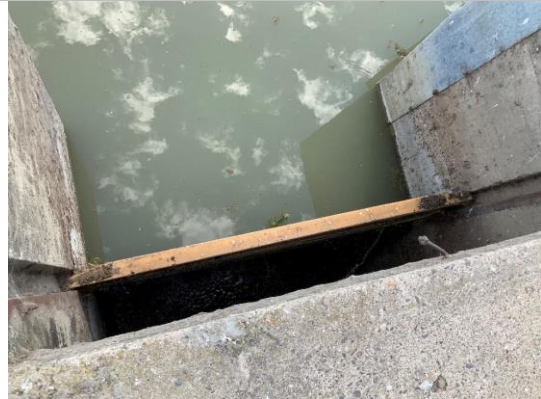
Photo 3 of 3 : UCIP_SP_2022_69772_103859.jpg

LS view from timber bridge: wooden flashboards in metal slots.

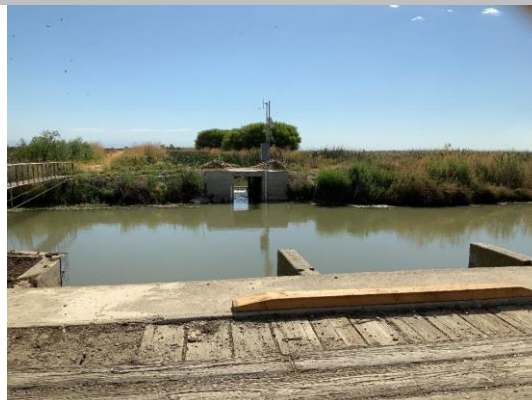
Photo 2 of 3 : UCIP_SP_2022_69751_103864.jpg

LS view from timber bridge.

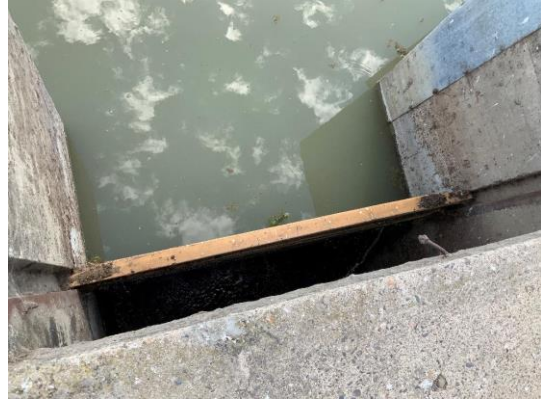
Photo 3 of 3 : UCIP_SP_2022_69751_103865.jpg

LS view from timber bridge.

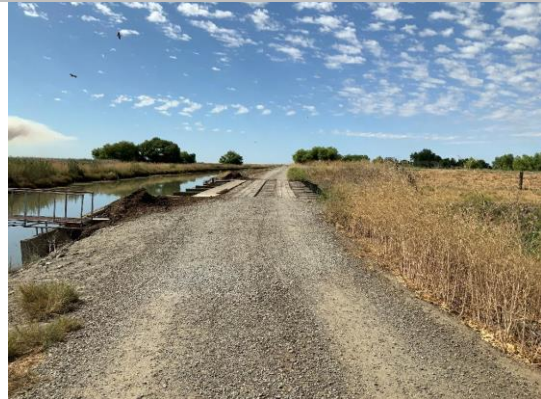
Photo 1 of 3 : UCIP_SP_2022_69752_103869.jpg

UCIP Comments: 06/09/2021 The record has been upgraded from No Action Needed to Non-Urgent. Structure is functioning and in good standing. No permit was found authorizing this encroachment. CVFPB will need to review crossing to determine owner. The UCIP inspection was completed with GEI staff, H.Dunn. (P.Espinoza ? GEI)

View from levee crown.

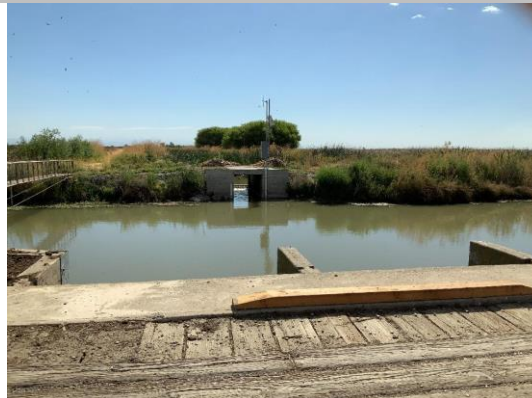
Photo 2 of 3 : UCIP_SP_2022_69753_103876.jpg

Comment Code					
Inspector Comment					
FS_ID:69753 DS_ID:19721 EP_NO: N/A Repair Type: Non-Urgent Crossing Status: Found UCIP Comments: 06/09/2021 The record has been upgraded from No Action Needed to Non-Urgent. Structure is functioning and in good standing. No permit was found authorizing this encroachment. CVFPB will need to review crossing to determine owner. The UCIP inspection was completed with GEI staff, H.Dunn. (P.Espinoza ? GEI) 10/27/2017 This structure is inspected annually under the Structure and Channel Summer Inspection (part of the Levee Inspection Program) conducted by the DWR Flood Project Integrity and Inspection Branch (FPIIB). (O. Magana - DWR UCIP) FIELD_STRUCT_DESC: [Owens Creek Irrigation Structure] 4 of 7: 96-inch by 168-inch reinforced concrete gravity irrigation opening. Metal slots on the waterside (WS) for wooden flashboards. Timber bridge across irrigation structure. [Additional Reference(s): DWR Levee Log, 2002 (HLM 1.00), listed as a seven 8-foot by 14-foot reinforced concrete structure, known as Owens Creek Structure] FS Date: 9/9/2021 1:43:00 PM

LS view from timber bridge.

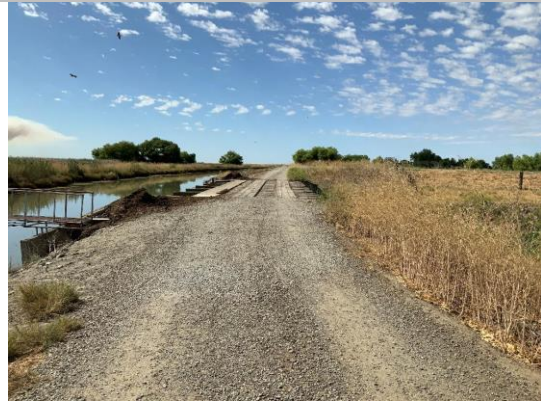
Photo 1 of 3 : UCIP_SP_2022_69754_103881.jpg

UCIP Comments: 06/09/2021 The record has been upgraded from No Action Needed to Non-Urgent. Structure is functioning and in good standing. No permit was found authorizing this encroachment. CVFPB will need to review crossing to determine owner. The UCIP inspection was completed with GEI staff, H.Dunn. (P.Espinoza ? GEI)

View from levee crown.

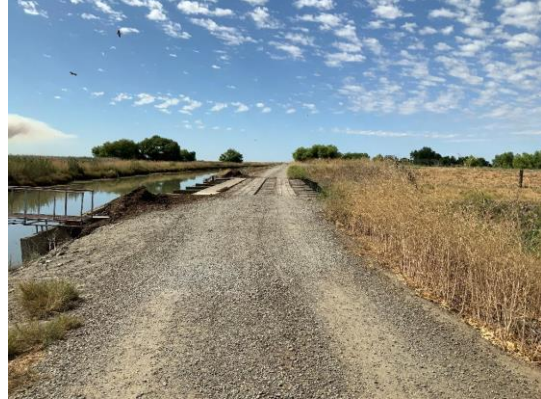
Photo 1 of 3 : UCIP_SP_2022_69755_103887.jpg

Comment Code						
Inspector Comment						
FS_ID:69755 DS_ID:19723 EP_NO: N/A Repair Type: Non-Urgent Crossing Status: Found UCIP Comments: 06/09/2021 The record has been upgraded from No Action Needed to Non-Urgent. Structure is functioning and in good standing. No permit was found authorizing this encroachment. CVFPB will need to review crossing to determine owner. The UCIP inspection was completed with GEI staff, H.Dunn. (P.Espinoza ? GEI) 10/27/2017 This structure is inspected annually under the Structure and Channel Summer Inspection (part of the Levee Inspection Program) conducted by the DWR Flood Project Integrity and Inspection Branch (FPIIB). (O. Magana - DWR UCIP) FIELD_STRUCT_DESC: [Owens Creek Irrigation Structure] 6 of 7: 96-inch by 168-inch reinforced concrete gravity irrigation opening. Metal slots on the waterside (WS) for wooden flashboards. Timber bridge across irrigation structure. [Additional Reference(s): DWR Levee Log, 2002 (HLM 1.00), listed as a seven 8-foot by 14-foot reinforced concrete structure, known as Owens Creek Structure] FS Date: 6/9/2021 2:15:00 PM

View from levee crown.

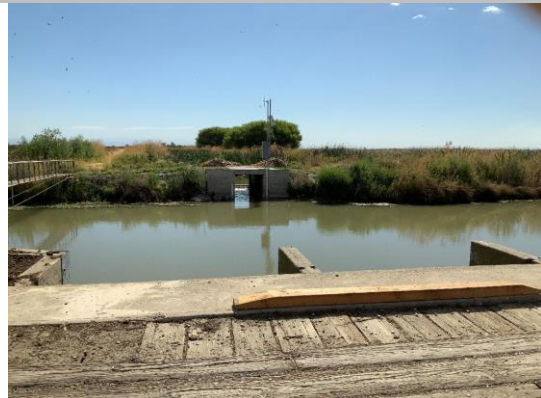
Photo 2 of 3 : UCIP_SP_2022_69755_103888.jpg

LS view from timber bridge.

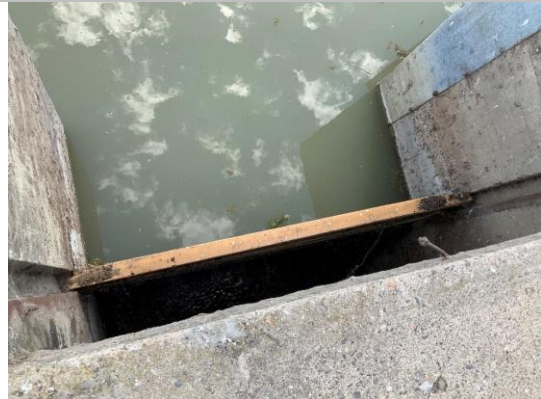
Photo 3 of 3 : UCIP_SP_2022_69755_103889.jpg

LS view from timber bridge: wooden flashboards in metal slots.

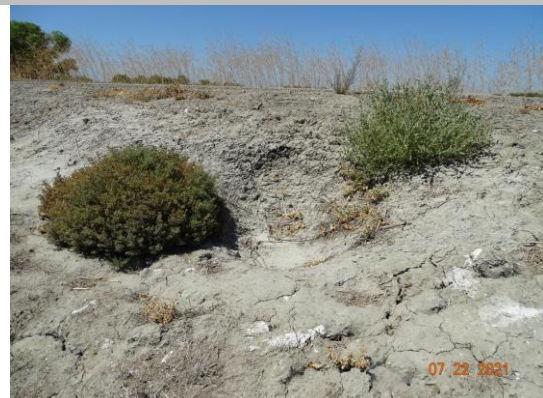
Photo 1 of 1 : SP_2022_NA0010_138_22_20220308_00020.jpg

LM Start	1.04	Rating **	M	Issue No.	22
LM End	1.04	Issue Type +	Ma	Location *	WS
Category	Earthen Levee			GPS Latitude/Longitude	
				Start	End
Item	Slope Stability			37.220281 °	37.220281 °
				-120.698287 °	-120.698287 °
DWR ID	DWR_NA0010_22A_f_2021_22				
Comment Code					
S1 : Repair slope instability.					
Inspector Comment

View of the erosion pocket on the levee slope (Fall 2021).

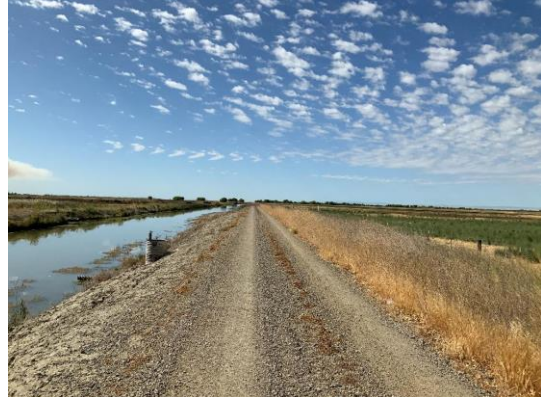
Photo 1 of 3 : UCIP_SP_2022_69880_103899.jpg

FS_ID:69880
DS_ID:19936
EP_NO: N/A
Repair Type: Non-Urgent
Crossing Status: Found
UCIP Comments: 06/09/2021 The record remains Non-Urgent. Appears abandoned due to headwall not being found on LS. (CMP) riser has no lid, causing a safety hazard; debris visible inside riser, recommend clearing out unless confirmed abandoned. Limited inspection on WS due to water and on LS due to dense vegetation, recommend removal of LS vegetation. No permit was found authorizing this encroachment. CVFPB will need to review crossing to determine owner. The UCIP inspection was completed with GEI staff, H.Dunn. (P.Espinoza ? GEI)

04/15/2014 Slide gate rusted and does not function. Headwall buried at LS toe. Pipe appears abandoned and if so should be done so properly. (W. Wylie - DWR UCIP)
FIELD_STRUCT_DESC: 8-inch corrugated metal gravity irrigation pipe through the levee, 7 feet below the crown. Slide gate in a 36-inch corrugated metal pipe (CMP) riser on the waterside (WS) slope. Concrete headwall on the landside (LS) end. [Additional Reference(s): DWR Levee Log, 2002 (HLM 1.57), listed as a 8-inch corrugated metal pipe (CMP). USACE San Joaquin O&M Manual, Unit 601 Part 1 (SJR601.1), 1967, Revised 25 May 2011, (HLM 1.57), listed as a 8-inch CMP]
FS Date: 6/9/2021 2:54:00 PM

View from levee crown.

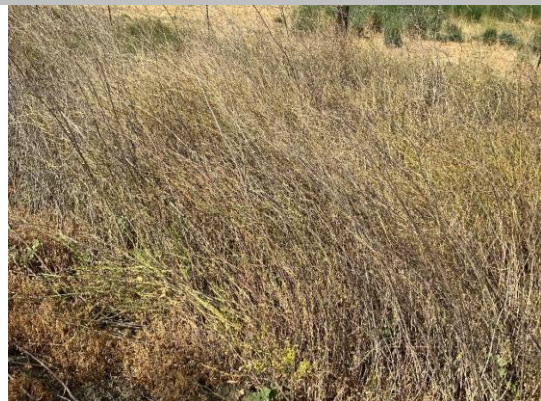
Photo 2 of 3 : UCIP_SP_2022_69880_103905.jpg

LS view: Slope from crown, dense vegetation.

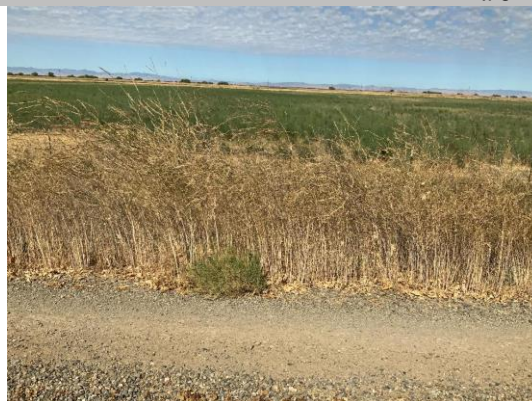
Photo 3 of 3 : UCIP_SP_2022_69880_103906.jpg

LS view: Toe from crown, dense vegetation.

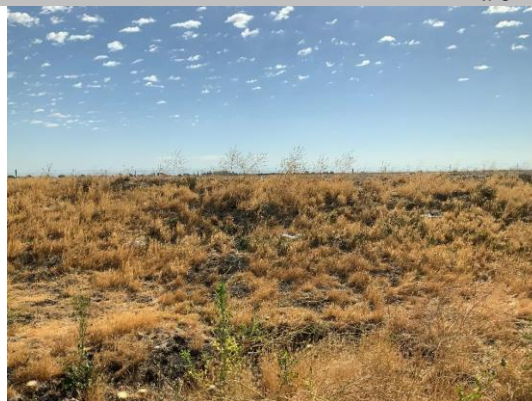
Photo 3 of 3 : UCIP_SP_2022_69883_103914.jpg

LS view: Slope from toe, no headwall visible.

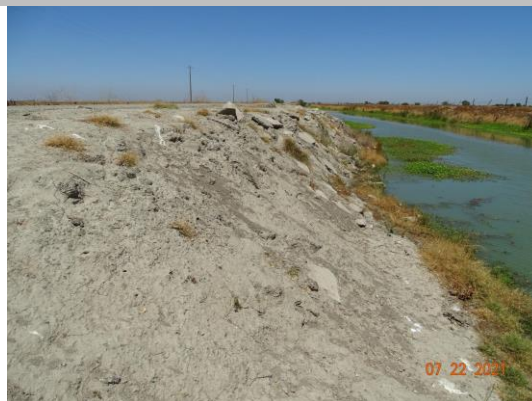
Photo 1 of 2 : SP_2022_NA0010_138_3_20220308_00005.jpg

07/22/2021: From 2020 to present, no significant changes were observed during the annual survey. In some areas, the levee shoulder width is up to 8 ft. There is some crushed concrete on the levee slope. 09/12/2019: The erosion has damaged entire levee slope. The livestock traffic likely has caused the erosion.

7/22/2021: View of the erosion looking downstream.

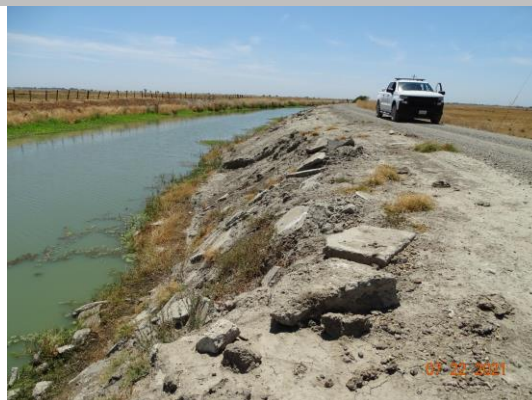
Photo 2 of 2 : SP_2022_NA0010_138_3_20220308_00006.jpg

7/22/2021: View of the eroded levee slope looking upstream.

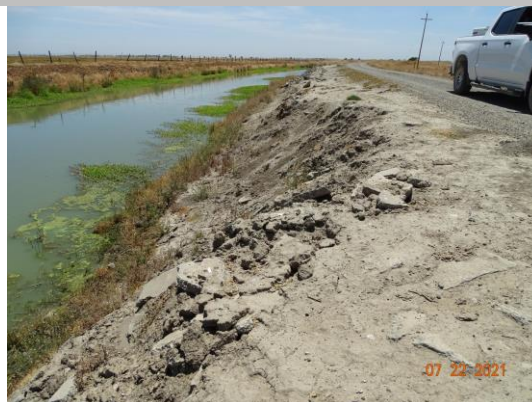
Photo 2 of 2 : SP_2022_NA0010_138_4_20220308_00008.jpg

7/22/2021: View of the erosion looking upstream.

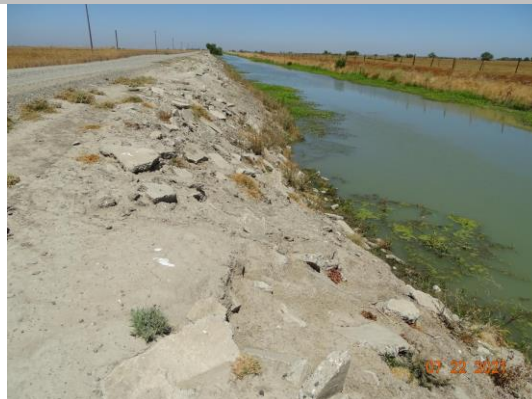
Photo 1 of 2 : SP_2022_NA0010_138_7_20220308_00010.jpg

07/22/2021: No significant changes were observed since the previous inspection.

08/18/2020: The erosion has been covered with loose fill and crushed concrete pieces. A nearly vertical slope remains at the levee toe in some sections. The site will likely worsen again during the next high water.

09/12/2019: The erosion has damaged entire levee slope. The livestock activity likely has caused the erosion.

7/22/2021: View of the erosion and crushed concrete on the slope.

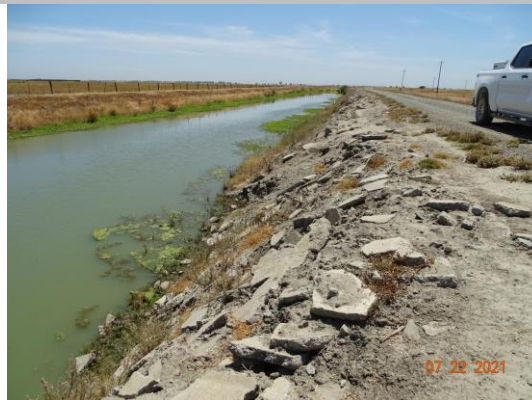
Photo 2 of 2 : SP_2022_NA0010_138_7_20220308_00011.jpg

7/22/2021: View of the erosion looking upstream.

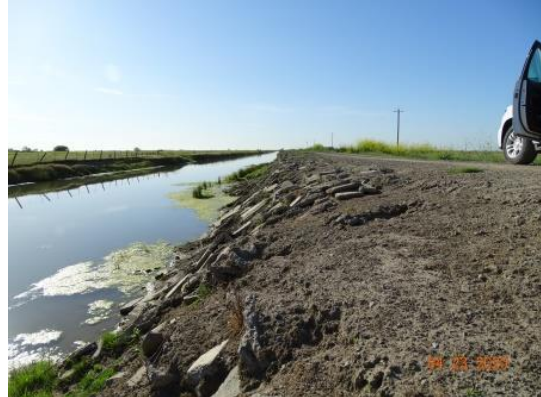
Photo 1 of 1 : SP_2022_NA0010_138_9_20220308_00013.jpg

LM Start	3.64	Rating **	A/W	Issue No.	9
LM End	3.69	Issue Type +	Ma	Location *	WS
Category	Earthen Levee			GPS Latitude/Longitude	
				Start	End
Item	Erosion / Livestock			37.253362 °	37.253862 °
				-120.717873 °	-120.718507 °
DWR ID	DWR_NA0010_22A_f_2016_9				
Comment Code					
E4 : Repair the levee slope damaged by livestock and prevent large animal access.					
Inspector Comment					
Broken concrete has been placed to limit further erosion caused by livestock. Monitor.

View of waterside slope looking upstream. (Spring 2020)

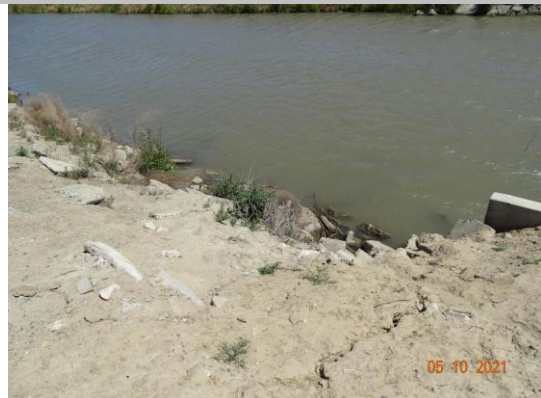
Photo 1 of 1 : SP_2022_NA0010_138_14_20220308_00016.jpg

LM Start	3.82	Rating **	M	Issue No.	14
LM End	3.82	Issue Type +	Ma	Location *	WS
Category	Earthen Levee			GPS Latitude/Longitude	
				Start	End
Item	Erosion / Livestock			37.255239 °	37.255239 °
				-120.720142 °	-120.720142 °
DWR ID	DWR_NA0010_22A_f_2017_14				
Comment Code					
E4 : Repair the levee slope damaged by livestock and prevent large animal access.					
Inspector Comment					
Broken concrete previously placed to stabilize the slope has washed out.

Damage to the waterside slope. (Spring 2021)

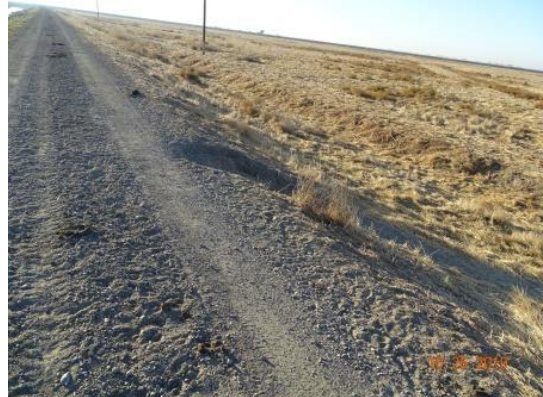
Photo 1 of 1 : SP_2022_NA0010_138_15_20220308_00017.jpg

LM Start	4.11	Rating **	M	Issue No.	15
LM End	4.11	Issue Type +	Ma	Location *	LS
Category	Earthen Levee			GPS Latitude/Longitude	
				Start	End
Item	Erosion / Livestock			37.258353 °	37.258353 °
				-120.723824 °	-120.723824 °
DWR ID	DWR_NA0010_22A_f_2019_15				
Comment Code					
E4 : Repair the levee slope damaged by livestock and prevent large animal access.					
Inspector Comment

View of erosion in the landside slope and shoulder from livestock traffic. (Fall 2019)

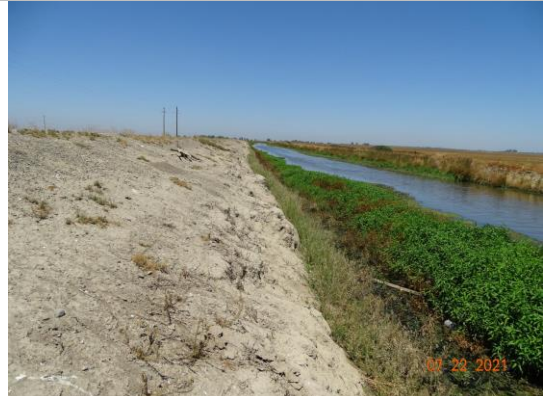
Photo 1 of 2 : SP_2022_NA0010_138_10_20220308_00014.jpg

LM Start	4.26	Rating **	U	Issue No.	10
LM End	4.30	Issue Type +	Ma	Location *	WS
Category	Supplemental			GPS Latitude/Longitude	
				Start	End
Item	DWR Erosion Survey			37.260111 °	37.260111 °
				-120.725900 °	-120.725900 °
DWR ID	NA0010U22RM2.25				
Comment Code					
Inspector Comment					
Site ID: NA0010U22RM2.25					
07/22/2021: From 2020 to present, no significant changes were observed during the annual survey.					
09/12/2019: Erosion has developed into the lower levee slope. Loose material was observed at the site.

7/22/2021: View of the erosion looking downstream.

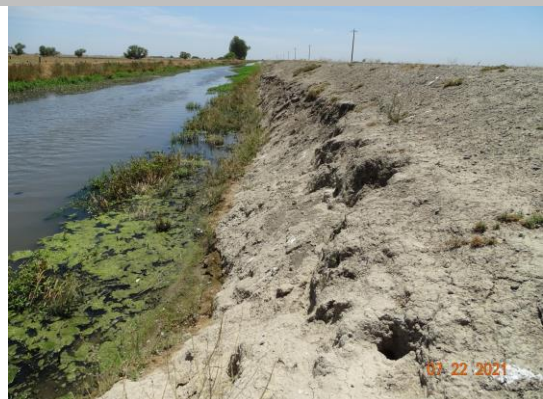
Photo 2 of 2 : SP_2022_NA0010_138_10_20220308_00015.jpg

7/22/2021: Close-up view of the erosion looking upstream.

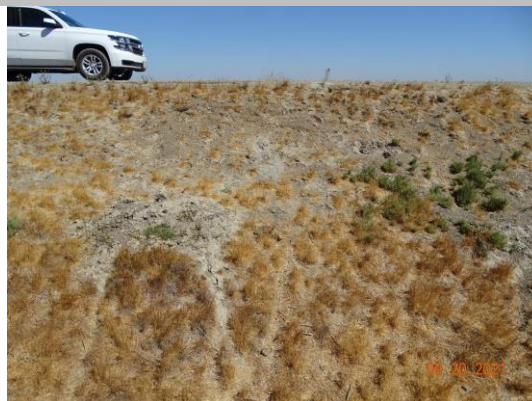
Photo 1 of 1 : SP_2022_NA0010_138_21_20220308_00019.jpg

LM Start	4.42	Rating **	M	Issue No.	21
LM End	4.42	Issue Type +	Ma	Location *	LS
Category	Earthen Levee			GPS Latitude/Longitude	
				Start	End
Item	Animal Control			37.261573 °	37.261573 °
				-120.727622 °	-120.727622 °
DWR ID	DWR_NA0010_22A_f_2021_21				
Comment Code					
A3 : No rodents visible, but rodent burrows visible; need to backfill and compact or grout burrows.					
Inspector Comment					
District has placed a bait station at the location.

View of displaced earth and rodent holes in the landside slope. (Fall 2021)

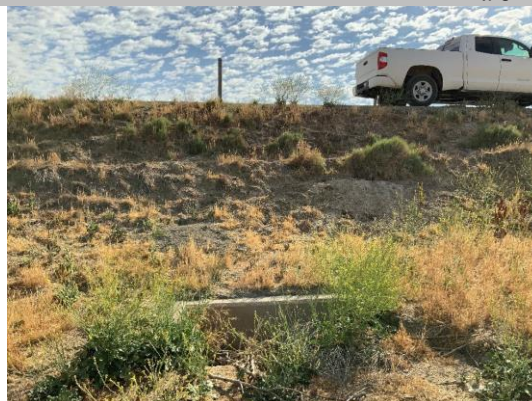
Photo 3 of 3 : UCIP_SP_2022_69884_103919.jpg

Comment Code						
Inspector Comment						
FS_ID:69884 DS_ID:19938 EP_NO: N/A Repair Type: Non-Urgent Crossing Status: Found UCIP Comments: 06/09/2021 The record remains Non-Urgent. Appears abandoned due to the LS headwall being buried in sediment and debris buildup, recommend clearing out. Inlet pipe on WS is not visible due to water in channel at the time of the survey. Limited inspection on both WS and LS pipe inlet/outlet. No permit was found authorizing this encroachment. CVFPB will need to review crossing to determine owner. The UCIP inspection was completed with GEI staff, H.Dunn. (P.Espinoza ? GEI) 04/15/2014 Need to contact owner. Pipe silted in on LS toe. Appears abandoned and if so should be done so properly. (W. Wylie - DWR UCIP) FIELD_STRUCT_DESC: 48-inch corrugated metal irrigation siphon pipe through the levee, 10 feet below the crown. Slide gate in a 60-inch corrugated metal pipe (CMP) riser on the waterside (WS) slope. Concrete headwall on the landside (LS) end. WS end capped with a 0.25-inch steel plate. [Additional Reference(s): DWR Levee Log, 2002 (HLM 5.48), listed as a 48-inch corrugated metal pipe (CMP). USACE San Joaquin O&M Manual, Unit 601 Part 1 (SJR601.1), 1967, Revised 25 May 2011, (HLM 5.48), listed as a 48-inch CMP] FS Date: 6/9/2021 3:14:00 PM

LS view: slope and buried headwall at toe.

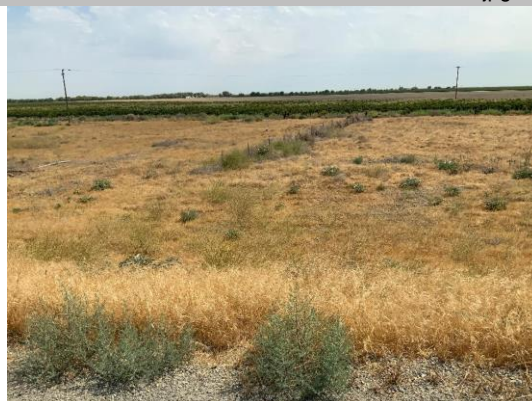
Photo 2 of 3 : UCIP_SP_2022_68585_102571.jpg

Comment Code					
Inspector Comment					
FS_ID:68585 DS_ID:19944 EP_NO: N/A Repair Type: Non-Urgent Crossing Status: Not Found UCIP Comments: 07/19/2021 The record has been upgraded from No Action Needed to Non-Urgent. Pipe not found by visual inspection. No permit was found authorizing this encroachment. CVFPB will need to review crossing to determine owner. Pile of small pipes seen on LS toe, possibly removed pipe from this DSID, contact owner to confirm status of pipe. The UCIP inspection was completed with GEI staff, P. Espinoza. (H. Dunn ? GEI) FIELD_STRUCT_DESC: Underground telephone conduit of an unknown size or material at the centerline of the roadway, at an unknown depth. Provide a field description of this crossing. [Additional Reference(s): DWR Levee Log, 2002 (HLM 0.00), listed as an underground telephone cable]. FS Date: 7/19/2021

LS view: Toe from crown, no pipe visible.

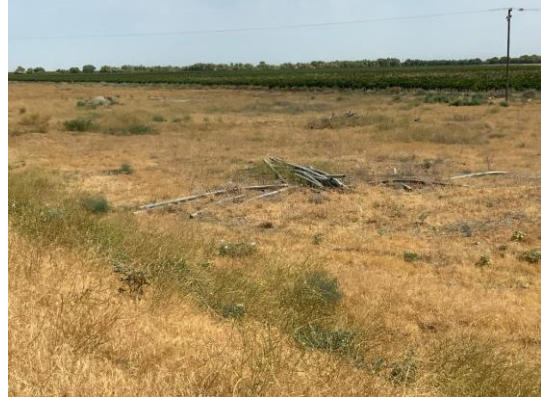
Photo 3 of 3 : UCIP_SP_2022_68585_102572.jpg

LS view: Pile of discarded pipe off the toe from crown.

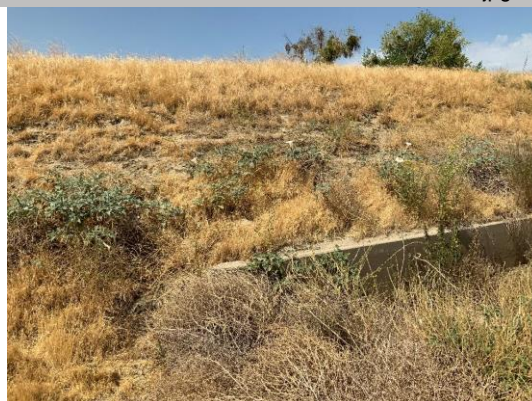
Photo 3 of 3 : UCIP_SP_2022_68586_102578.jpg

FS_ID:68586
 DS_ID:19945
 EP_NO: N/A
 Repair Type: Non-Urgent
 Crossing Status: Found
 UCIP Comments: 07/19/2021 The record remains Non-Urgent. Dense LS vegetation over pipe inlet, recommend removal. No permit was found authorizing this encroachment. CVFPB will need to review crossing to determine owner. The UCIP inspection was completed with GEI staff, P. Espinoza. (H. Dunn ? GEI) 04/03/2014 Excessive vegetation at inlet--recommend clearing. (W. Wylie - DWR UCIP)
 FIELD_STRUCT_DESC: 30-inch by 30-inch square reinforced concrete box gravity drainage culvert through the levee, 13 feet below the crown. Flap gate on the waterside (WS) end. Concrete headwall on the landside (LS) end. Concrete U-shaped headwall on the WS end. (Plans to construct a new discharge structure and to rehabilitate one existing diversion structure to return intercepted seepage to the San Joaquin River authorized under Permit No. 13085, 1981 - Diener, Dry River Farms). [Additional Reference(s): DWR Levee Log, 2002 (HLM 0.21), listed as a 30-inch square reinforced concrete box culvert (RCBC). USACE San Joaquin O&M Manual, Unit 601 Part 1 (SJR601.1), 1967, Revised 25 May 2011, (HLM 0.21), listed as a 2.5-foot by 2.5-foot RCBC]

LS view: Headwall and slope from toe.

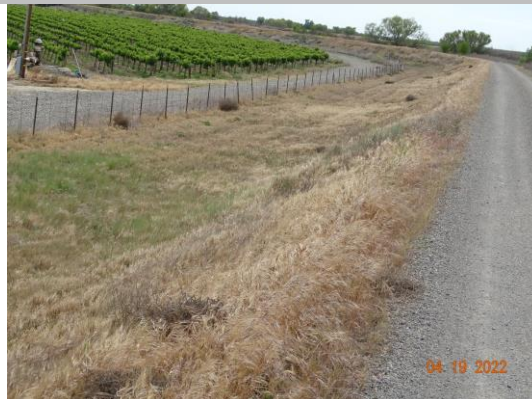
Photo 1 of 1 : SP_2022_NA0010_139_39_20220502_00067.jpg

LM Start	0.89	Rating **	M	Issue No.	39
LM End	1.06	Issue Type +	Ma	Location *	LS
Category	Earthen Levee			GPS Latitude/Longitude	
				Start	End
Item	Vegetation			36.773647 °	36.772714 °
				-120.270247 °	-120.267436 °
DWR ID	DWR_NA0010_23_s_2022_39				
Comment Code					
V1 : Control annual grass and weeds on the levee slopes and easements.					
Inspector Comment

Looking upstream at vegetation along the landside slope. (Spring 2022)

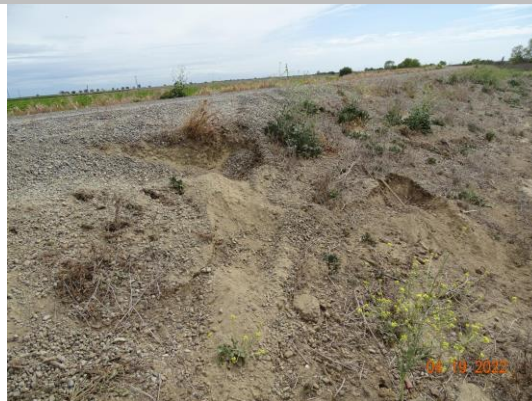
Photo 1 of 1 : SP_2022_NA0010_139_40_20220502_00068.jpg

LM Start	1.00	Rating **	M	Issue No.	40
LM End	1.00	Issue Type +	Ma	Location *	WS
Category	Earthen Levee			GPS Latitude/Longitude	
				Start	End
Item	Erosion / Vehicle Traffic			36.772875 °	36.772875 °
				-120.268436 °	-120.268436 °
DWR ID	DWR_NA0010_23_s_2022_40				
Comment Code					
E6 : Repair the levee slope damaged by vehicle traffic and prevent access where possible.					
Inspector Comment

Damage from vehicle traffic to the waterside slope. (Spring 2022)

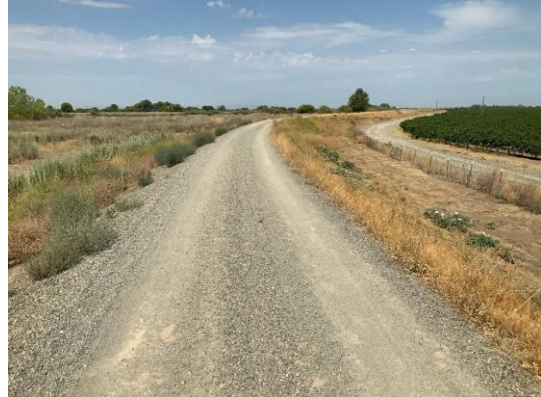
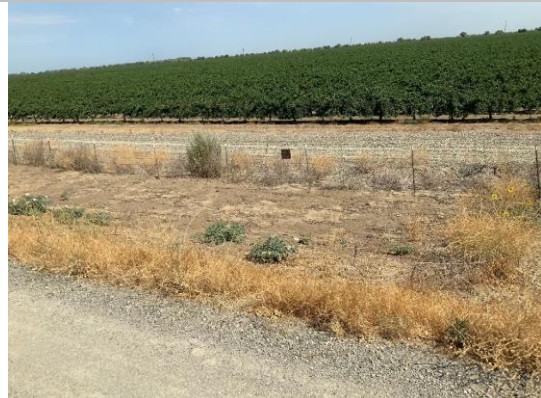
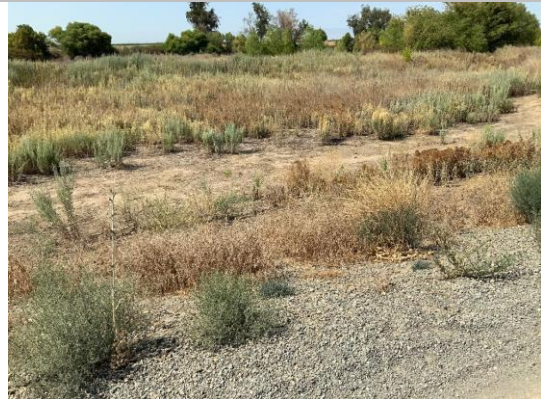
Comment Code					
Inspector Comment					
FS_ID:68587 DS_ID:19946 EP_NO: 13735 Repair Type: Non-Urgent Crossing Status: Not Found UCIP Comments: 07/19/2021 The record has been upgraded from No Action Needed to Non-Urgent. Pipe not found by visual inspection. DWR DMP geophysical study did not confirm presence of pipe through levee. Record will remain in UCIP's inspection records until future Levee Improvement Project can confirm no crossing was found through the levee. The UCIP inspection was completed with GEI staff, P. Espinoza. (H. Dunn ? GEI) FIELD_STRUCT_DESC: 24-inch coated steel gravity drainage pipe through the levee, 2 feet below the crown. Steel cutoff wall at the center of the levee. Siphon breaker with protective housing on the apex of the pipe on the landside (LS) shoulder. Galvanized siphon vent pipe on the LS shoulder. Rock revetment on the waterside (WS) slope. Roadway padded over crossing. (Plans to install two 24-inch steel discharge pipelines through the levee to dispose of seepage water collected in farm sumps Nos. 8 and 12 authorized under Permit No. 13735, 1983 - Rio Seco Farm). [Additional Reference(s): DWR Levee Log, 2002 (HLM 1.07), listed as a 24-inch steel pipe]. FS Date: 7/19/2021

Levee crown.

LS view: Toe from crown, no pipe visible.

WS view: Toe from crown, no pipe visible.

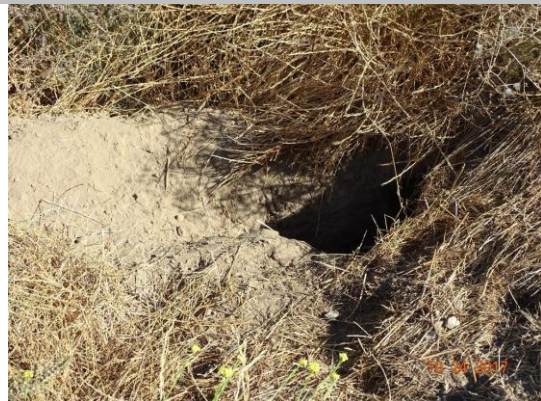
Photo 1 of 1 : SP_2022_NA0010_139_26_20220308_00006.jpg

LM Start	1.09	Rating **	A/W	Issue No.	26
LM End	1.09	Issue Type +	Ma	Location *	LS
Category	Earthen Levee			GPS Latitude/Longitude	
				Start	End
Item	Animal Control			36.772743 °	36.772743 °
				-120.266800 °	-120.266800 °
DWR ID	DWR_NA0010_23_f_2017_26				
Comment Code					
A3 : No rodents visible, but rodent burrows visible; need to backfill and compact or grout burrows.					
Inspector Comment

Looking at the landside slope.

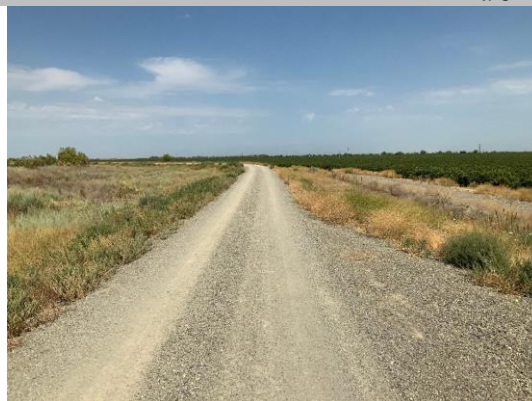
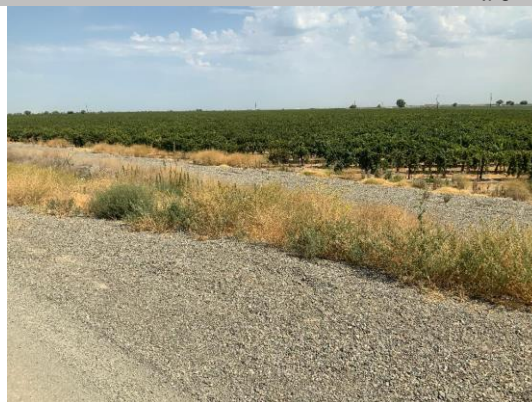
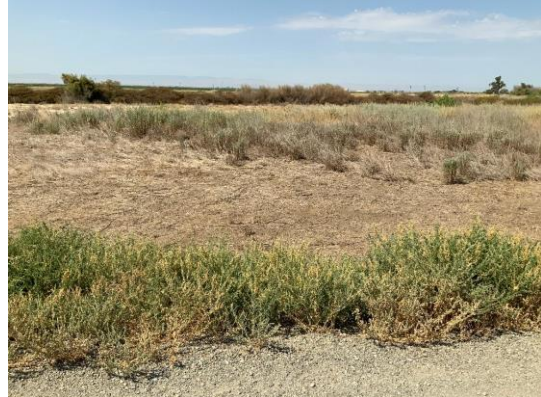
Comment Code						
Inspector Comment						
FS_ID:68588						
DS_ID:19947						
EP_NO: N/A						
Repair Type: Non-Urgent						
Crossing Status: Not Found						
UCIP Comments: 07/19/2021 The record has been upgraded from No						
Action Needed to Non-Urgent. Pipe not found by visual inspection. No						
permit was found authorizing this encroachment. CVFPB will need to						
review crossing to determine owner. The UCIP inspection was						
completed with GEI staff, P. Espinoza. (H. Dunn ? GEI)						
FIELD_STRUCT_DESC: Telephone conduit of an unknown size or						
material under the levee crown, at an unknown depth. [Additional						
Reference(s): DWR Levee Log, 2002 (HLM 1.46), listed a a phone						
cable].						
FS Date: 7/19/2021

Levee crown.

LS view: Toe from crown, no pipe or powerline visible.

WS view: Toe from crown, no pipe or powerline visible.
