**Flood Control Project Maintenance
Levee Inspections
LMA District Cover Sheet**

Lower San Joaquin Levee District

**Flood Control Project Maintenance
Levee Inspections
Unit Cover Sheet**

Levee Inspection Report By Mile - Spring 2022

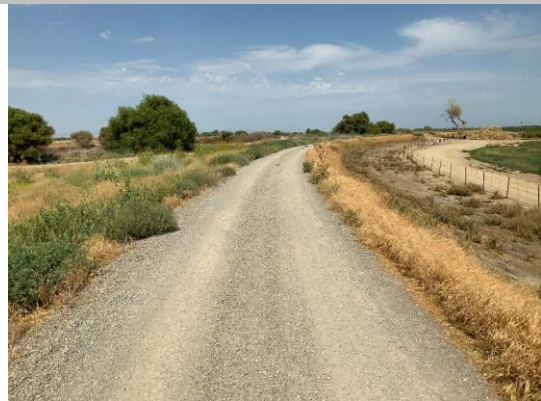
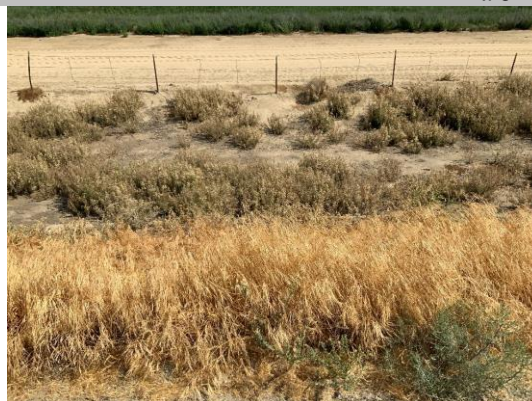
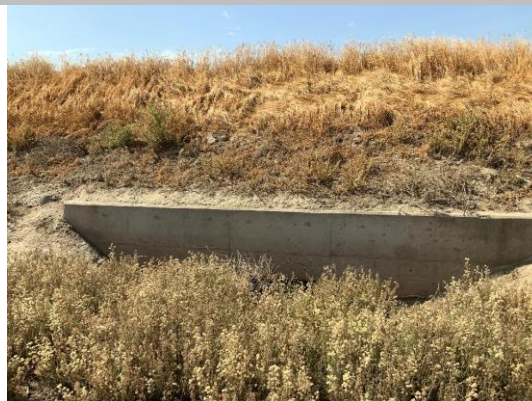
FS_ID:68589
DS_ID:19948
EP_NO: N/A
Repair Type: Non-Urgent
Crossing Status: Found
UCIP Comments: 07/19/2021 The record remains Non-Urgent. Sediment buildup inside LS pipe inlet, recommend cleaning out. WS flapgate inaccessible due to barbed wire. No permit was found authorizing this encroachment. CVFPB will need to review crossing to determine owner. The UCIP inspection was completed with GEI staff, P. Espinoza. (H. Dunn ? GEI) 04/03/2014 Appears abandoned and if so should be done properly. Discharge channel is blocked by sand and soil making drain ineffective. Soil buildup at inlet on LS toe. Need to contact owner. (W. Wylie - DWR UCIP)
FIELD_STRUCT_DESC: 30-inch by 30-inch square reinforced concrete box gravity drainage culvert through the levee, 11 feet below the crown. Flap gate on the waterside (WS) end. Concrete headwall on the landside (LS) end. Concrete U-shaped headwall on the WS end.
[Additional Reference(s): DWR Levee Log, 2002 (HLM 1.64), listed as a 30-inch square reinforced concrete box culvert [RCBC]].

Levee crown.

LS view: Toe from crown.

LS view: Headwall and slope from toe.

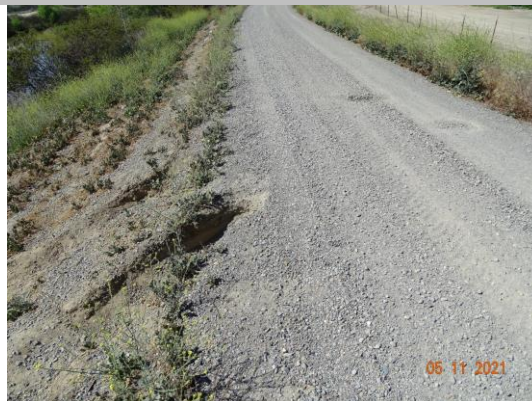
Photo 1 of 1 : SP_2022_NA0010_139_28_20220308_00007.jpg

LM Start	1.90	Rating **	U	Issue No.	28
LM End	1.90	Issue Type +	Ma	Location *	WS
Category	Earthen Levee			GPS Latitude/Longitude	
				Start	End
Item	Erosion / Vehicle Traffic			36.772731 °	36.772731 °
				-120.253590 °	-120.253590 °
DWR ID	DWR_NA0010_23_s_2021_28				
Comment Code					
E6 : Repair the levee slope damaged by vehicle traffic and prevent access where possible.					
Inspector Comment

View of damage to the waterside slope and shoulder. (Spring 2021)

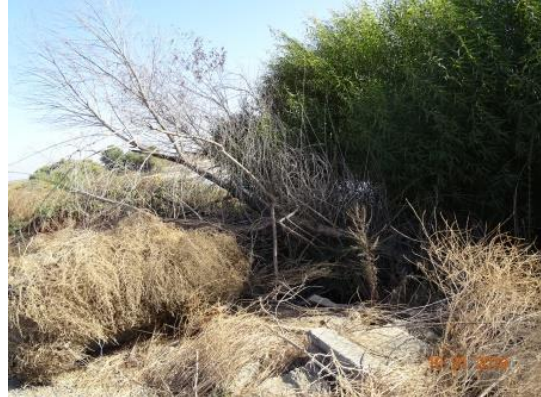
Photo 1 of 1 : SP_2022_NA0010_139_1_20220308_00001.jpg

LM Start	1.91	Rating **	M	Issue No.	1
LM End	1.91	Issue Type +	Ma	Location *	WS
Category	Earthen Levee			GPS Latitude/Longitude	
				Start	End
Item	Encroachments			36.772943 °	36.772943 °
				-120.253511 °	-120.253511 °
DWR ID	DWR_NA0010_23_s_2015_1				
Comment Code					
TR : Tree or limb					
Inspector Comment					
There is a downed tree on the waterside slope.

View of fallen tree on the waterside slope. (Fall 2019)

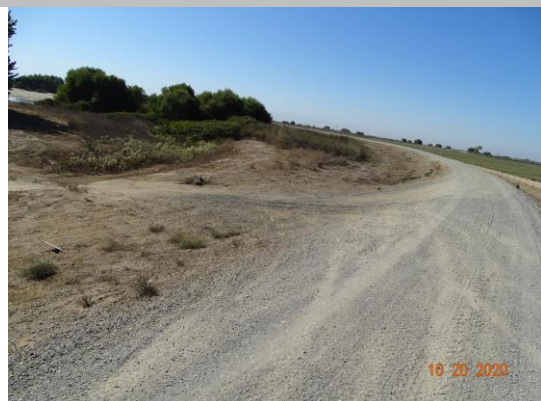
Photo 1 of 1 : SP_2022_NA0010_139_16_20220308_00003.jpg

LM Start	2.12	Rating **	M	Issue No.	16
LM End	2.12	Issue Type +	En	Location *	WS
Category	Earthen Levee			GPS Latitude/Longitude	
				Start	End
Item	Encroachments			36.775507 °	36.775507 °
				-120.251670 °	-120.251672 °
DWR ID	DWR_NA0010_23_s_2013_16				
Comment Code					
RA : Ramp					
Inspector Comment					
Ramp constructed on waterside slope.

View of ramp constructed on waterside slope. (Fall 2020)

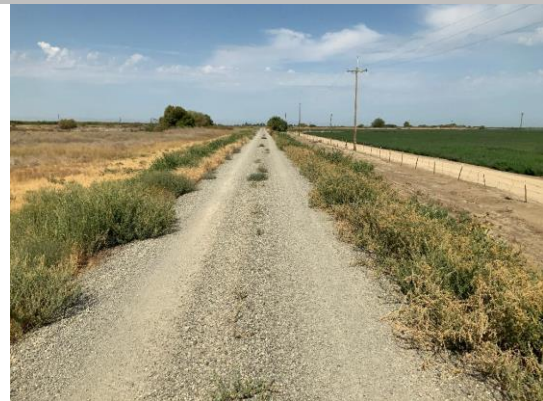
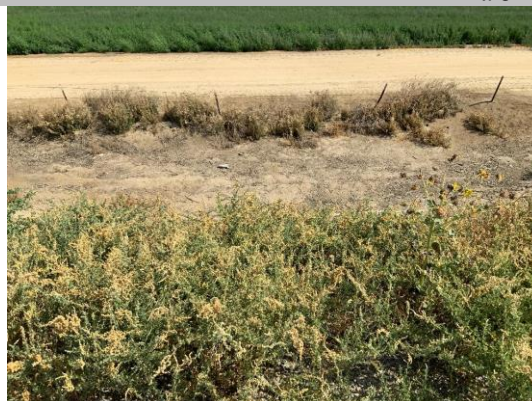
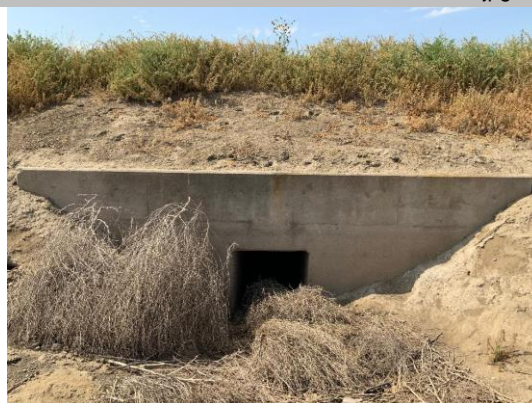
Comment Code					
Inspector Comment					
FS_ID:68590 DS_ID:19951 EP_NO: N/A Repair Type: Non-Urgent Crossing Status: Found UCIP Comments: 07/19/2021 The record has been upgraded from No Action Needed to Non-Urgent. Sediment and tumbleweed buildup over and inside LS pipe inlet, recommend removal. No permit was found authorizing this encroachment. CVFPB will need to review crossing to determine owner. The UCIP inspection was completed with GEI staff, P. Espinoza. (H. Dunn ? GEI) FIELD_STRUCT_DESC: 30-inch by 30-inch square reinforced concrete box gravity drainage culvert through the levee, 9 feet below the crown. Flap gate on the waterside (WS) end. Concrete headwall on the landside (LS) end. Concrete U-shaped headwall on the WS end. [Additional Reference(s): DWR Levee Log, 2002 (HLM 2.99), listed as a 30-inch reinforced concrete box culvert (RCBC)]. FS Date: 7/19/2021

Levee crown.

LS view: Toe from crown.

LS view: Headwall and slope from toe.

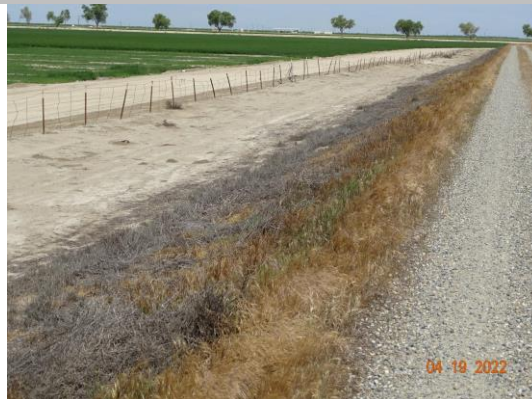
Photo 1 of 1 : SP_2022_NA0010_139_42_20220502_00069.jpg

LM Start	3.41	Rating **	M	Issue No.	42
LM End	4.33	Issue Type +	Ma	Location *	LS
Category	Earthen Levee			GPS Latitude/Longitude	
				Start	End
Item	Vegetation			36.776070 °	36.783869 °
				-120.234633 °	-120.225213 °
DWR ID	DWR_NA0010_23_s_2022_42				
Comment Code					
V1 : Control annual grass and weeds on the levee slopes and easements.					
Inspector Comment

View of vegetation on the landside slope. (Spring 2022)

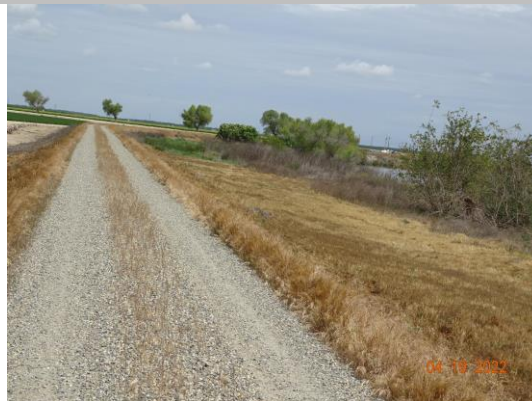
Photo 1 of 1 : SP_2022_NA0010_139_43_20220502_00070.jpg

LM Start	3.42	Rating **	M	Issue No.	43
LM End	9.74	Issue Type +	Ma	Location *	WS
Category	Earthen Levee			GPS Latitude/Longitude	
				Start	End
Item	Vegetation			36.776123 °	36.807597 °
				-120.234629 °	-120.168835 °
DWR ID	DWR_NA0010_23_s_2022_43				
Comment Code					
V1 : Control annual grass and weeds on the levee slopes and easements.					
Inspector Comment

Looking upstream along the waterside slope. (Spring 2022)

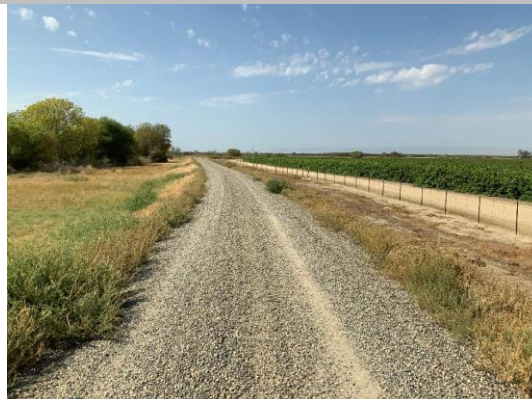
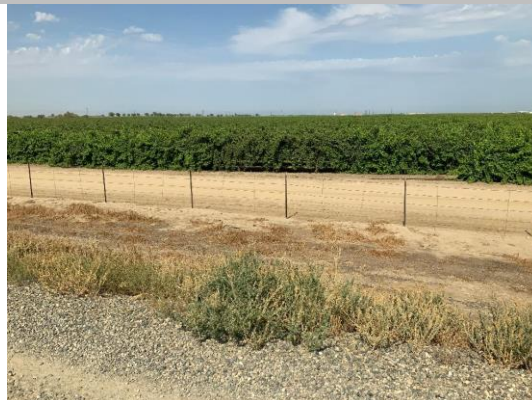
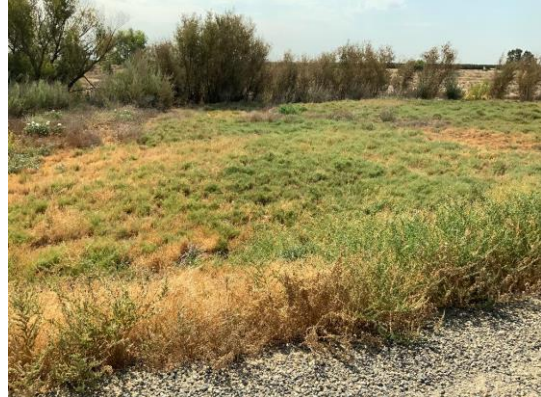
Comment Code						
Inspector Comment						
FS_ID:68783 DS_ID:19952 EP_NO: N/A Repair Type: Non-Urgent Crossing Status: Not Found UCIP Comments: 07/19/2021 The record remains Non-Urgent. Pipe not found by visual inspection. As a safety measure, need to coordinate with owner to determine status of line and to obtain maintenance and inspection records to confirm integrity of line through the levee or abandonment. No permit was found authorizing this encroachment. CVFPB will need to review crossing to determine owner. The UCIP inspection was completed with GEI staff, P. Espinoza. (H. Dunn ? GEI) 04/03/2014 Verify abandonment with gas company. Need to contact owner to determine status of crossing. Need date of last inspection and confirmation that crossing is still in operable condition. (W. Wylie - DWR UCIP) FIELD_STRUCT_DESC: 4-inch natural gas pipeline of an unknown material through the levee, 6 feet below the crown. Gas line gaging area and compressor station in the channel, 50 feet from the waterside (WS) toe. [Additional Reference(s): DWR Levee Log, 2002 (HLM 4.72), listed as a 4-inch gas line] FS Date: 7/19/2021

Levee crown.

LS view: Toe from crown, no pipe or markers visible.

WS view: Toe from crown, no pipe or markers visible.

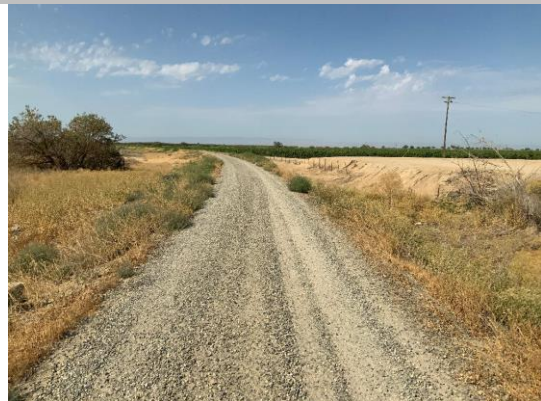
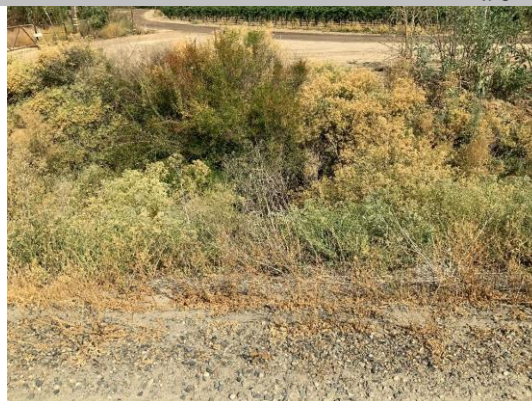
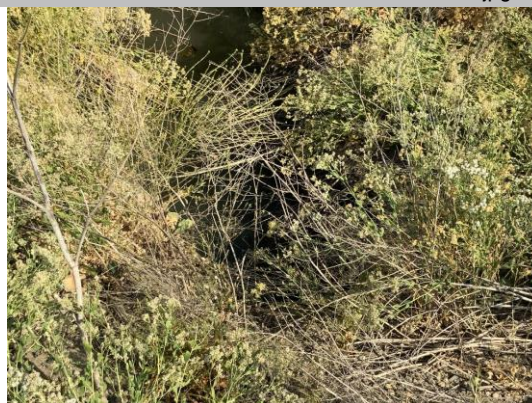
FS_ID:68909
DS_ID:19953
EP_NO: N/A
Repair Type: Non-Urgent
Crossing Status: Found
UCIP Comments: 07/19/2021 The record remains Non-Urgent. WS pipe inlet underwater during inspection. LS pipe outlet not visible due to dense vegetation, recommend removing vegetation. Limited inspection on both WS and LS ends. No permit was found authorizing this encroachment. CVFPB will need to review crossing to determine owner. The UCIP inspection was completed with GEI staff, P. Espinoza. (H. Dunn ? GEI) 04/03/2014 Heavy vegetation at inlet and outlet-- recommend clearing. (W. Wylie - DWR UCIP)
FIELD_STRUCT_DESC: 30-inch by 30-inch square reinforced concrete box gravity irrigation culvert through the levee, 10.7 feet below the crown. 4.5-foot by 7-foot concrete riser with slide gate on the waterside (WS) slope. Concrete U-shaped headwall on each end. 15-foot-long cobble revetted inlet channel. [Additional Reference(s): DWR Levee Log, 2002 (HLM 4.87), listed as a 30-inch square reinforced concrete box culvert (RCBC)].

Levee crown.

LS view: Toe from crown.

LS view: Pipe outlet covered by dense vegetation at toe.

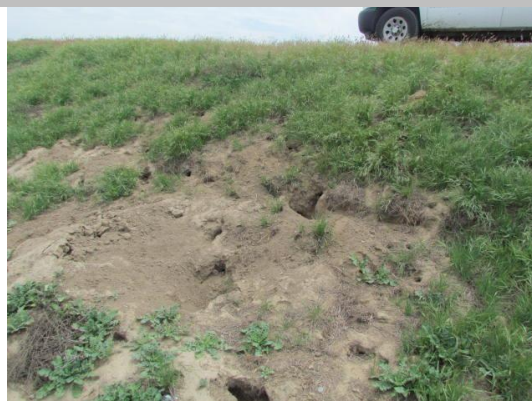
View of rodent burrow in the landside slope. (Fall 2018)

**Flood Control Project Maintenance
Levee Inspections**

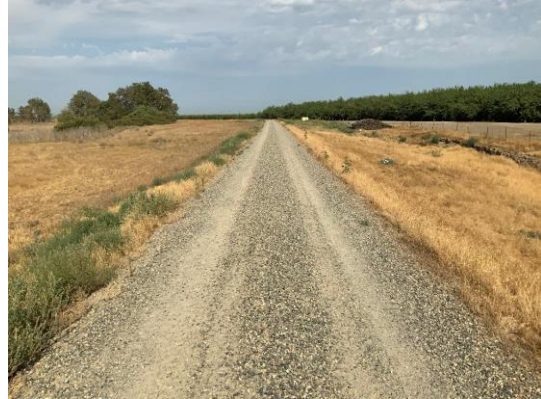
Photo 1 of 3 : UCIP_SP_2022_70681_90922.jpg

Comment Code						
Inspector Comment						
FS_ID:70681						
DS_ID:19629						
EP_NO: N/A						
Repair Type: Non-Urgent						
Crossing Status: Found						
UCIP Comments: 10/21/2020 Record remains Non-Urgent. No permit was found authorizing this encroachment. CVFPB will need to review crossing to determine owner. DWR DMP has not found internal issues, LOF between 1 and 2. Recommend inspection in 5 years. (B. Singh - GEI, O. Magana - DWR UCIP)04/09/2014 Dense vegetation blocks waterward and landward toes Recommend removing vegetation from both toes. Also sediment buildup in pipe visible from landward side. (W. Wylie - UCIP DMP)						
FIELD_STRUCT_DESC: 24-inch corrugated metal (CM) gravity drainage pipe through the levee, 9.0 feet below the crown. Flap gate on the waterside (WS) end. Brass cap No. 69 bench mark (BM) on the headwall on the landside (LS). [Additional Reference(s): DWR Levee Log, 2002, (HLM 10.24). USACE San Joaquin O&M Manual, Unit No. 601, Part No. 1, (SJR601.1), 1967, Revised 25 May 2011, (HLM 10.23)].

Overview of levee crown

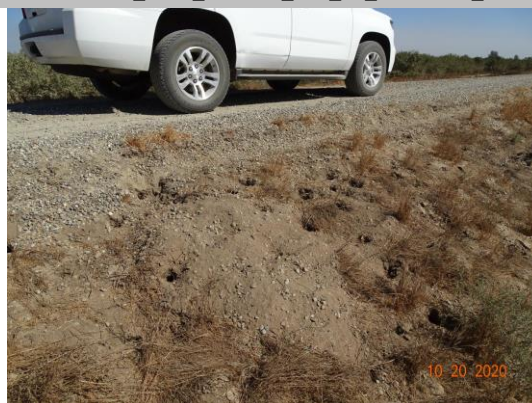
WS view: WS slope profile

Levee Inspection Report By Mile - Spring 2022

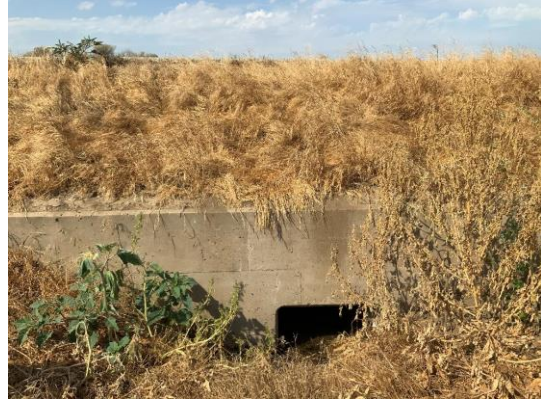
Waterway	Bank	Unit Miles	Inspection Start/End	Inspector
Unit No. 01 San Joaquin River	Right	22.52	04/05/2022 04/05/2022	Corey Fujitani

Photo 3 of 3 : UCIP_SP_2022_70682_91001.jpg

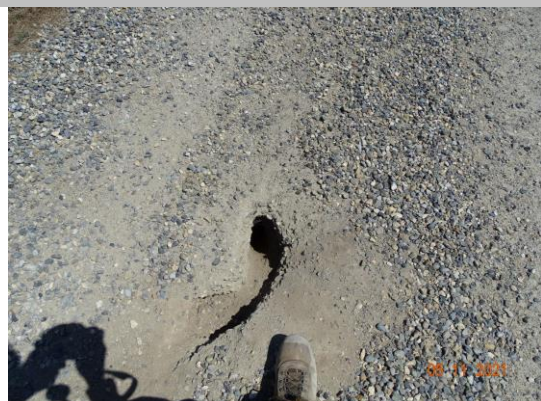
Inspector Comment

Photo 1 of 3 : UCIP_SP_2022_70683_92770.jpg

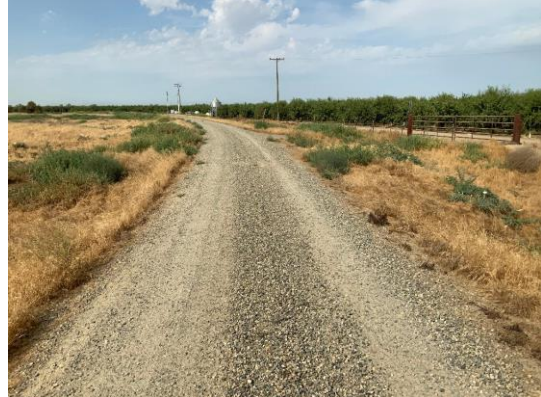
LM Start	10.69	Rating **	M	Issue No.	56 (cont)
LM End	10.69	Issue Type +	Ma	Location *	
Category	Supplemental		GPS Latitude/Longitude		
			Start	End	
Item	DWR UCIP LMA Responsibility		37.283710 °	37.283710 °	
			-120.833329 °	-120.833329 °	
DWR ID	19631

Waterway	Bank	Unit Miles	Inspection Start/End	Inspector
Unit No. 01 San Joaquin River	Right	22.52	04/05/2022 04/05/2022	Corey Fujitani

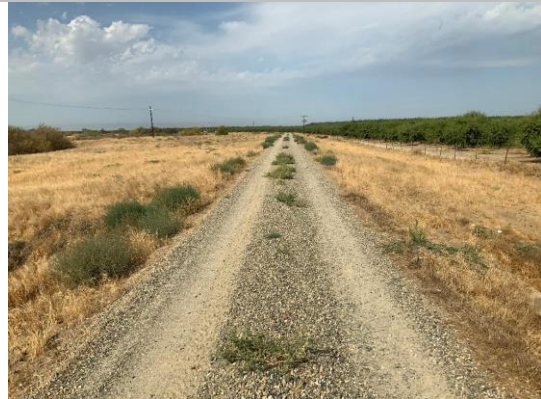
FS Date: 10/21/2020

Inspector Comment

Photo 1 of 3 : UCIP_SP_2022_70684_90929.jpg

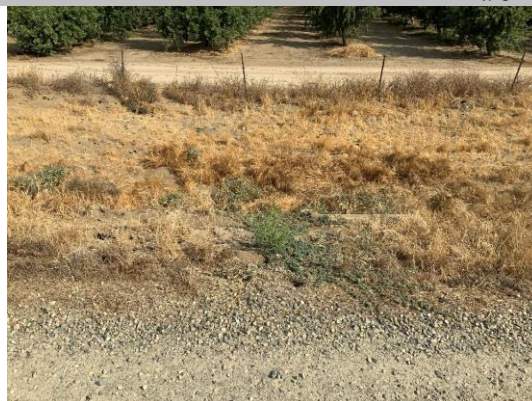
**Flood Control Project Maintenance
Levee Inspections**

Lower San Joaquin Levee District

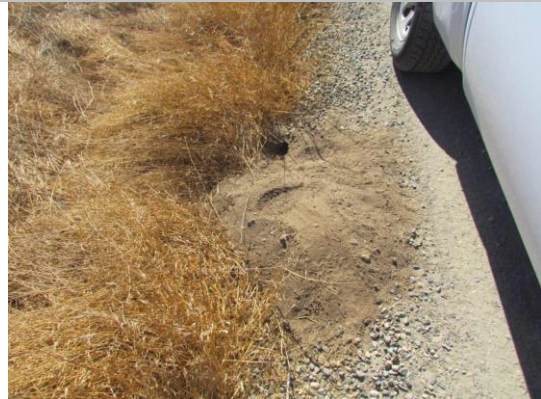
Levee Inspection Report By Mile - Spring 2022

**Flood Control Project Maintenance
Levee Inspections**

Waterway	Bank	Unit Miles	Inspection Start/End	Inspector
Unit No. 01 San Joaquin River	Right	22.52	04/05/2022 04/05/2022	Corey Fujitani

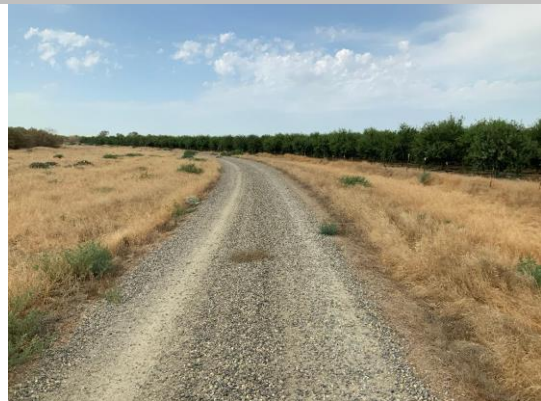
Photo 2 of 3 : UCIP_SP_2022_70685_90935.jpg

LM Start	11.14	Rating **	M	Issue No.	58 (cont)
LM End	11.14	Issue Type +	Ma	Location *

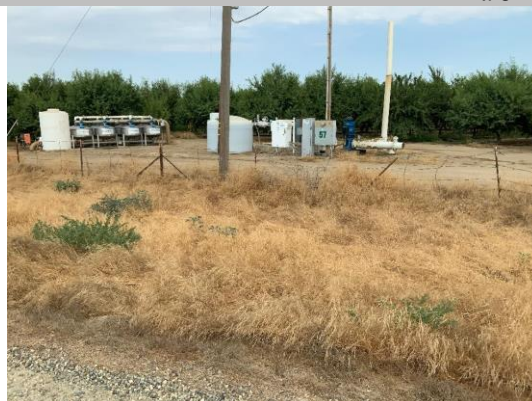
Rodent burrows in the landside slope. (Spring 2020)

**Flood Control Project Maintenance
Levee Inspections**

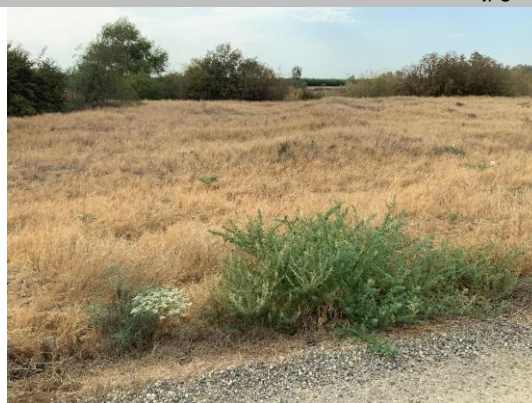
Lower San Joaquin Levee District

LM Start	11.37	Rating **	M	Issue No.	59	
LM End	11.37	Issue Type +	Ma	Location *		
Category	Supplemental			GPS Latitude/Longitude		
				Start		End
Item	DWR UCIP LMA Responsibility			37.275518 °	37.275518 °	
				-120.826052 °	-120.826052 °	
DWR ID	19814

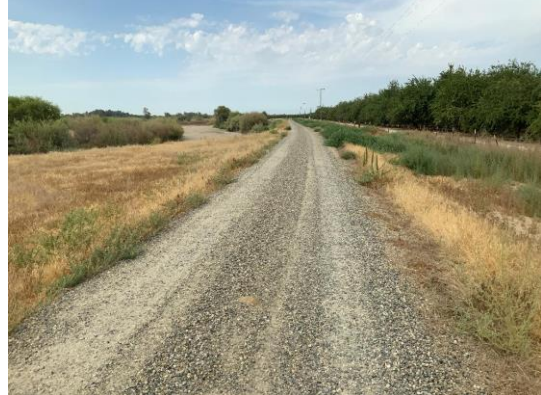
Levee Inspection Report By Mile - Spring 2022

* Location LS : Land Side N/A : Not Applicable WS : Water Side CR : Crown	** Rating A : Acceptable M : Minimally Acceptable U : Unacceptable	N : Not Inspected/Rated C : Corrected A/W : Acceptable but Monitor & Maintain	+ Issue Type Ma : Maintenance Deficiency Ob : Design & System Obsolescence En : Enforcement
--	--	---	---

Waterway	Bank	Unit Miles	Inspection Start/End	Inspector
Unit No. 01 San Joaquin River	Right	22.52	04/05/2022 04/05/2022	Corey Fujitani

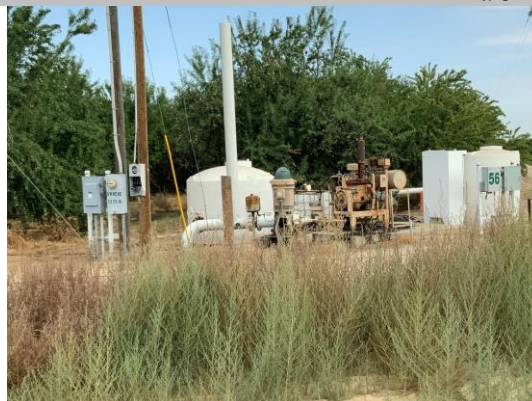
Photo 1 of 3 : UCIP_SP_2022_70687_92836.jpg

Overview of levee crown looking upstream towards pipe crossing, photo 1 of 2.

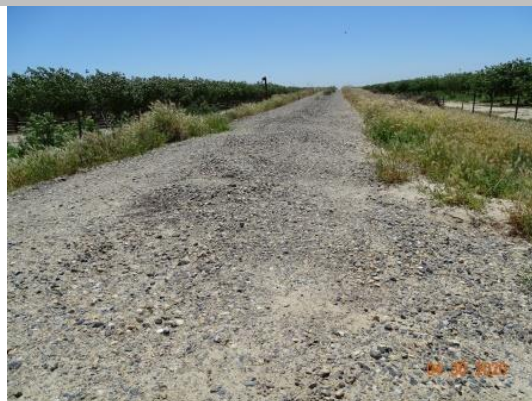
**Flood Control Project Maintenance
Levee Inspections**

* Location LS : Land Side N/A : Not Applicable WS : Water Side CR : Crown		** Rating A : Acceptable M : Minimally Acceptable U : Unacceptable N : Not Inspected/Rated C : Corrected A/W : Acceptable but Monitor & Maintain		+ Issue Type Ma : Maintenance Deficiency Ob : Design & System Obsolescence En : Enforcement	
--	--	---	--	---	--

Lower San Joaquin Levee District

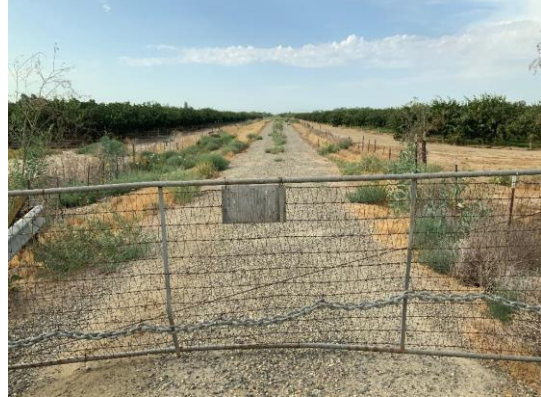
Photo 3 of 3 : UCIP_SP_2022_70687_90949.jpg

LM Start	11.53	Rating **	M	Issue No.	136
LM End	11.53	Issue Type +	Ma	Location *	LS
Category	Earthen Levee			GPS Latitude/Longitude	
				Start	End
Item	Animal Control			37.273150 °	37.273150 °
				-120.825630 °	-120.825630 °
DWR ID	DWR_NA0010_01_s_2021_136				
Comment Code					
A1 : Exterminate rodents and backfill and compact or grout burrows.					
Inspector Comment					
Rodents and burrows observed on landside slope and levee crown at this location.

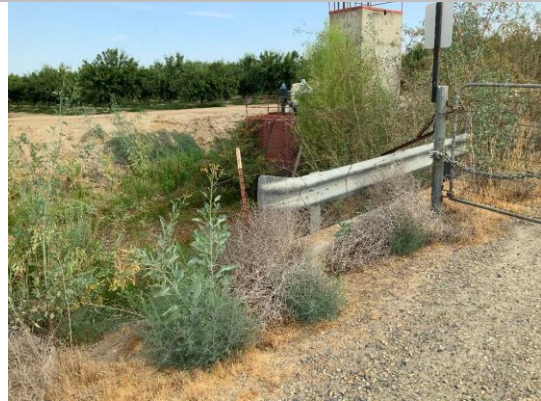
Photo 2 of 3 : UCIP_SP_2022_68911_102708.jpg

Comment Code					
Inspector Comment					
FS_ID:68911 DS_ID:19943 EP_NO: N/A Repair Type: Non-Urgent Crossing Status: Found UCIP Comments: 07/19/2021 The record remains Non-Urgent. Limited access to both LS and WS due to steep slopes and vegetation. Both WS outlet and LS inlet have sediment buildup, recommend clearing out. No permit was found authorizing this encroachment. CVFPB will need to review crossing to determine owner. This portion of the levee has a levee prism less than 3 feet, appears to be high ground. The UCIP inspection was completed with GEI staff, P. Espinoza. (H. Dunn ? GEI) 11/01/2018 Limited access to both LS and WS; assumed slide gates are still non-functional; Crossing has been downgraded from Urgent to Non-Urgent due to re-classification of damage slide gates. (O. Magana - DWR UCIP)07/20/2016 No change--same as previous inspection. (O. Magana - DWR UCIP)04/03/2014 Slide gate not functional. Slide gate channels heavily corroded (exfoliated) and likely impact functionality/structural integrity of gate. (W. Wylie - DWR UCIP) FIELD_STRUCT_DESC: [Gravelly Ford Canal Irrigation Structure] 1 of 2: 48-inch by 63-inch reinforced concrete box gravity irrigation culvert through the levee, 10 feet below the crown. Concrete U-shaped headwall on each end. Gear pedestal slide gate with wall bracket on the waterside (WS) headwall. 10-foot-long cobble revetted outlet channel. Guardrail on each shoulder. Slide gates on the WS. [Additional Reference(s): DWR Levee Log, 2002 (HLM 9.76), listed as a two 4.0-foot by 5.25-foot reinforced concrete box culvert (RCBC). USACE San Joaquin O&M Manual, Unit 601 Part 1 (SJR601.1), 1967, Revised 25 May 2011, (HLM 9.76), listed as a two 5.25-foot by 4-foot barrel RCBC] FS Date: 7/19/2021

LS view: Toe from crown.

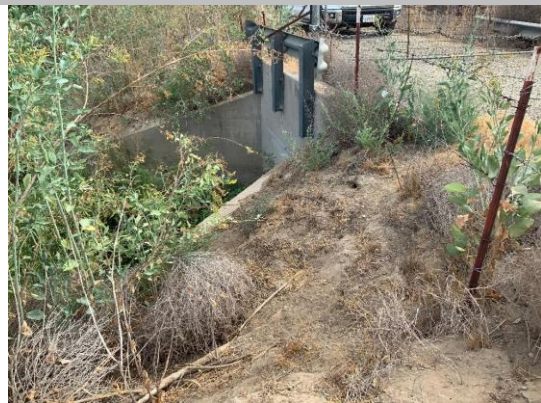
Photo 3 of 3 : UCIP_SP_2022_68911_102709.jpg

LS view: Slope and headwall from toe.

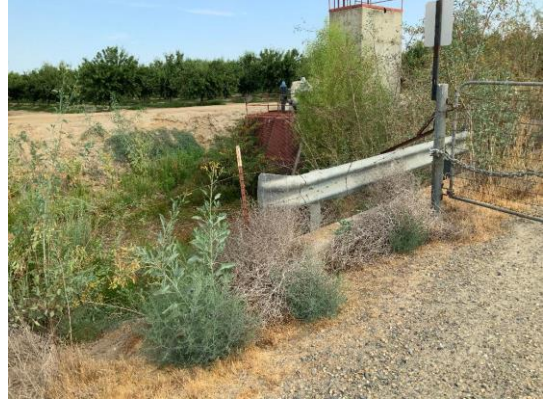
Photo 2 of 3 : UCIP_SP_2022_68912_102715.jpg

Comment Code					
Inspector Comment					
FS_ID:68912 DS_ID:19980 EP_NO: N/A Repair Type: Non-Urgent Crossing Status: Found UCIP Comments: 07/19/2021 The record remains Non-Urgent. Limited access to both LS and WS due to steep slopes and vegetation. Both WS outlet and LS inlet have sediment buildup, recommend clearing out. No permit was found authorizing this encroachment. CVFPB will need to review crossing to determine owner. This portion of the levee has a levee prism less than 3 feet, appears to be high ground. The UCIP inspection was completed with GEI staff, P. Espinoza. (H. Dunn ? GEI) 11/01/2018 Limited access to both LS and WS; assumed slide gates are still non-functional; Crossing has been downgraded from Urgent to Non-Urgent due to re-classification of damage slide gates. (O. Magana - DWR UCIP)07/20/2016 No change--same as previous inspection. (O. Magana - DWR UCIP)04/03/2014 Slide gate not functional. Slide gate channels heavily corroded (exfoliated) and likely impact functionality/structural integrity of gate. (W. Wylie - DWR UCIP) FIELD_STRUCT_DESC: [Gravelly Ford Canal Irrigation Structure] 2 of 2: 48-inch by 63-inch reinforced concrete box gravity irrigation culvert through the levee, 10 feet below the crown. Concrete U-shaped headwall on each end. Gear pedestal slide gate with wall bracket on the waterside (WS) headwall. 10-foot-long cobble revetted outlet channel. Guardrail on each shoulder. [Additional Reference(s): DWR Levee Log, 2002 (HLM 9.76), listed as a two 4.0-foot by 5.25-foot reinforced concrete box culvert (RCBC). USACE San Joaquin O&M Manual, Unit 601 Part 1 (SJR601.1), 1967, Revised 25 May 2011, (HLM 9.76), listed as a two 5.25-foot by 4-foot barrel RCBC]. FS Date: 7/19/2021

LS view: Toe from crown.

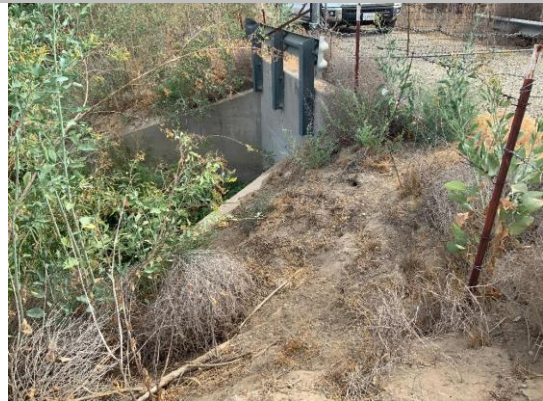
Photo 3 of 3 : UCIP_SP_2022_68912_102716.jpg

LS view: Slope and headwall from toe.

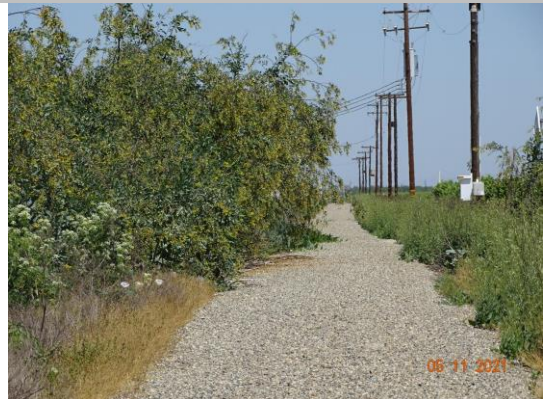
Photo 1 of 1 : SP_2022_NA0010_139_58_20220308_00014.jpg

LM Start	9.76	Rating **	M	Issue No.	58
LM End	9.81	Issue Type +	Ma	Location *	LS
Category	Earthen Levee			GPS Latitude/Longitude	
				Start	End
Item	Trim / Thin Trees			36.807810 °	36.808553 °
				-120.168829 °	-120.168827 °
DWR ID	DWR_NA0010_23_f_2018_58				
Comment Code					
T4 : Trim trees over roadway to at least 12 feet above ground level.					
Inspector Comment					
Woody vegetation is partially blocking crown and landside slope.

Woody vegetation on landside toe obstructing landside of crown. (Spring 2021)

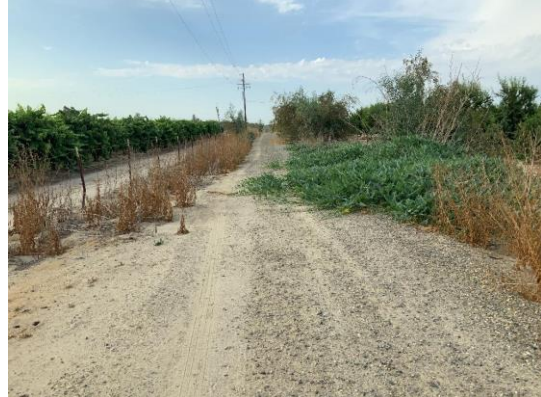
Photo 1 of 3 : UCIP_SP_2022_68618_102724.jpg

FS_ID:68618
DS_ID:19684
EP_NO: 15399
Repair Type: Non-Urgent
Crossing Status: Indicator Found
UCIP Comments: 07/19/2021 The record has been upgraded from No Action Needed to Non-Urgent. As a safety measure, need to coordinate with owner to determine status of line and to obtain maintenance and inspection records to confirm integrity of line through the levee. This portion of the levee has a levee prism less than 3 feet, appears to be high ground. The UCIP inspection was completed with GEI staff, P. Espinoza. (H. Dunn ? GEI11/30/2015 Markers are now present at this location for gas line. Photos provided by DWR Inspector in November 2015. (O. Magana - DWR UCIP)04/03/2014 Need to install gasoline markers at crossing. (W. Wylie - DWR UCIP)
FIELD_STRUCT_DESC: 6-inch coated steel natural gas pipeline through the levee, at an unknown depth. Location identified on Pacific Gas and Electric Company (PG&E) website. No signs on levee.

Levee crown.

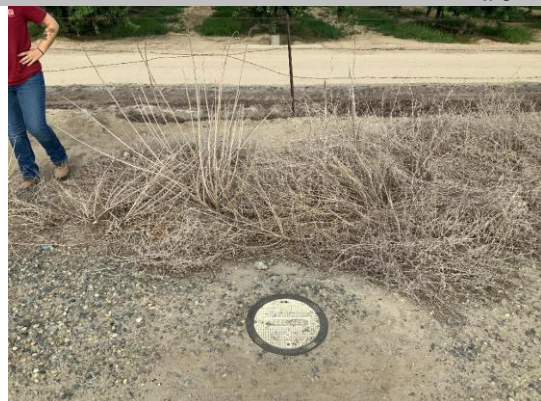
Photo 2 of 3 : UCIP_SP_2022_68618_102727.jpg

LS view: Toe from crown, manhole visible.

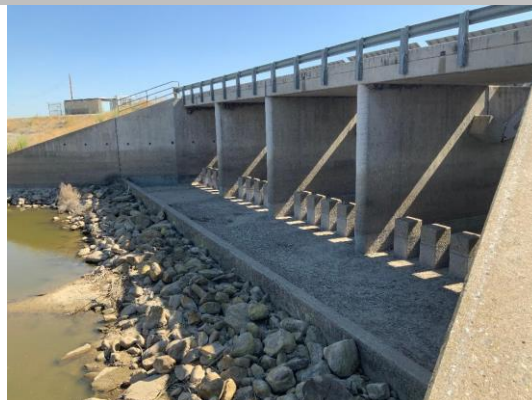
Photo 2 of 3 : UCIP_SP_2022_68628_102744.jpg

LS view: Inlets and headwall visible from toe.

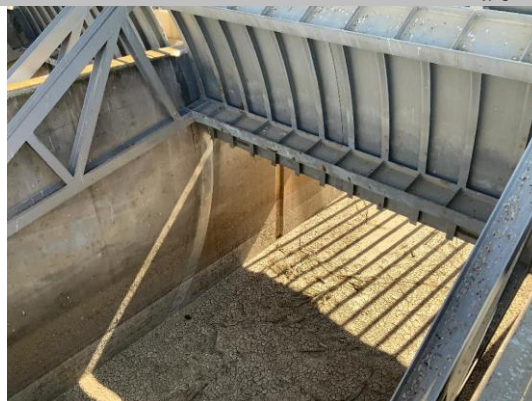
Photo 3 of 3 : UCIP_SP_2022_68628_102747.jpg

LS view: Closeup of inlet at toe.

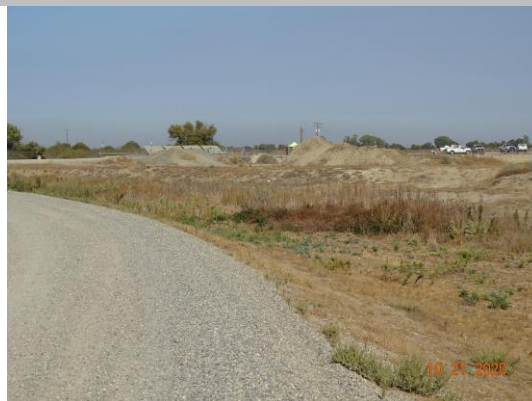
Photo 1 of 1 : SP_2022_NA0010_140_47_20220308_00016.jpg

LM Start	0.06	Rating **	M	Issue No.	47
LM End	0.06	Issue Type +	En	Location *	WS
Category	Earthen Levee			GPS Latitude/Longitude	
				Start	End
Item	Encroachments			36.772328 °	36.772328 °
				-120.285117 °	-120.285117 °
DWR ID	DWR_NA0010_24_s_2014_47				
Comment Code					
MA : Material					
Inspector Comment					
The District constructed a berm on waterside slope. The berm is being used for staging of earthen material.

Berm and material constructed off the waterside slope. (Fall 2020)

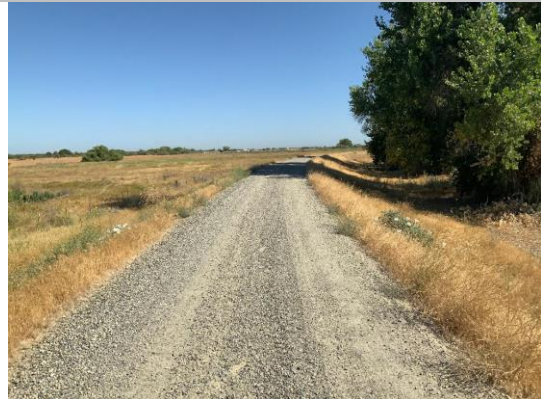
Photo 1 of 3 : UCIP_SP_2022_68915_102757.jpg

Comment Code						
Inspector Comment						
FS_ID:68915 DS_ID:19685 EP_NO: 15399 Repair Type: Non-Urgent Crossing Status: Not Found UCIP Comments: 07/20/2021 The record is Non-Urgent. Pipe not found by visual inspection. As a safety measure, need to coordinate with owner to determine status of line and to obtain maintenance and inspection records to confirm integrity of line through the levee. The UCIP inspection was completed with GEI staff, P. Espinoza. (H. Dunn ? GEI) FIELD_STRUCT_DESC: 6-inch coated steel natural gas pipeline through the levee, 3 feet below the crown. Control valve 10 feet off the landside (LS) toe. Pipeline extends under the channel and through the levee on the opposite bank. (Plans to install a 6-inch welded steel natural gas pipeline under the channel and within both levees of the San Joaquin River and the Chowchilla Bypass authorized under Permit No. 15399, 1990 - California Gas Gathering, Inc.). FS Date: 7/20/2021

Levee crown.

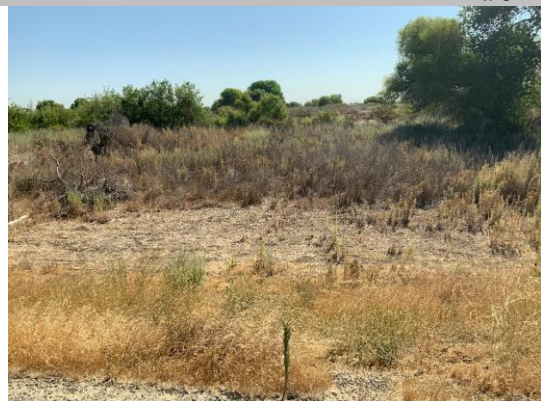
Photo 2 of 3 : UCIP_SP_2022_68915_102759.jpg

LS view: Toe from crown, no pipe visible.

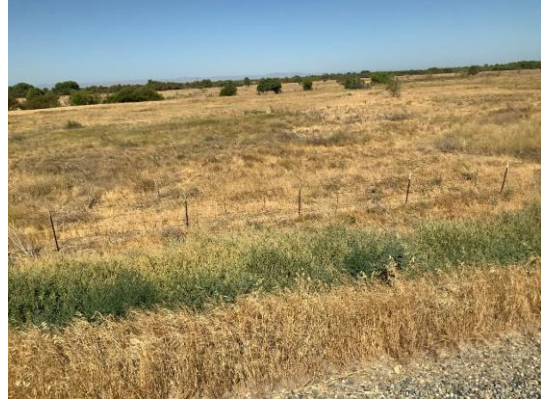
Photo 3 of 3 : UCIP_SP_2022_68915_102758.jpg

WS view: Toe from crown, no pipe visible.

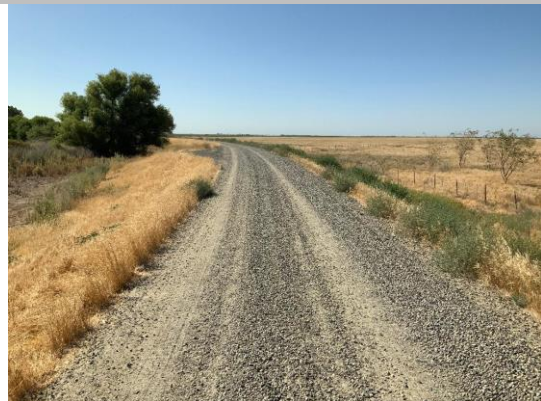
Photo 1 of 3 : UCIP_SP_2022_68631_102762.jpg

FS_ID:68631
 DS_ID:19955
 EP_NO: N/A
 Repair Type: Non-Urgent
 Crossing Status: Found
 UCIP Comments: 07/20/2021 The record remains Non-Urgent. Cannot access LS inlet due to barbed wire, but appears to have sediment buildup. WS flapgate inaccessible due to steep hill and dense vegetation, recommend clearing vegetation and sediment out on both WS and LS inlet/outlet. No permit was found authorizing this encroachment. CVFPB will need to review crossing to determine owner. The UCIP inspection was completed with GEI staff, P. Espinoza. (H. Dunn ? GEI)04/08/2014 No access available to confirm condition of landward side headwall. Recommend clearing debris along fence. Surface erosion near concrete headwall on landward side was present. (O. Magana - DWR UCIP)
 FIELD_STRUCT_DESC: 30-inch by 30-inch square reinforced concrete box gravity drainage culvert through the levee, 13.5 feet below the crown. Flap gate on the waterside (WS) end. Concrete headwall on each end. [Additional Reference(s): DWR Levee Log, 2002 (HLM 0.49), listed as a 30-inch square concrete culvert].

Levee crown.

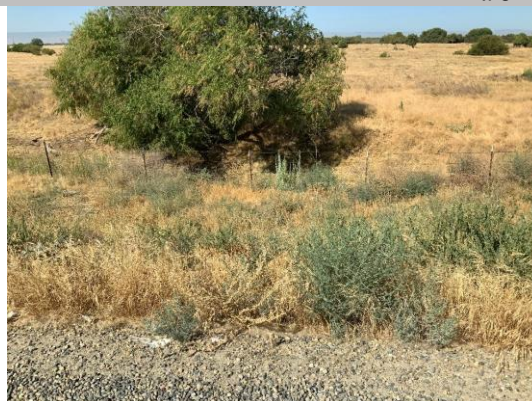
Photo 2 of 3 : UCIP_SP_2022_68631_102763.jpg

LS view: Toe from crown.

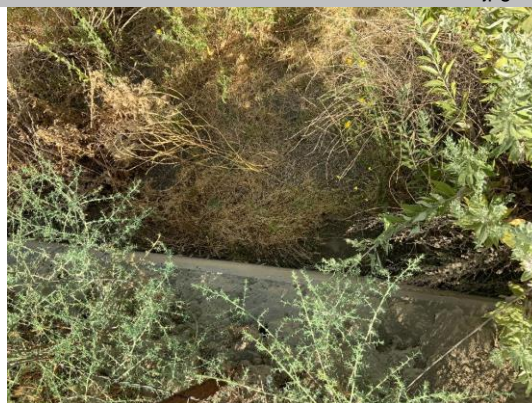
Photo 3 of 3 : UCIP_SP_2022_68631_102764.jpg

LS view: Top of headwall at toe.

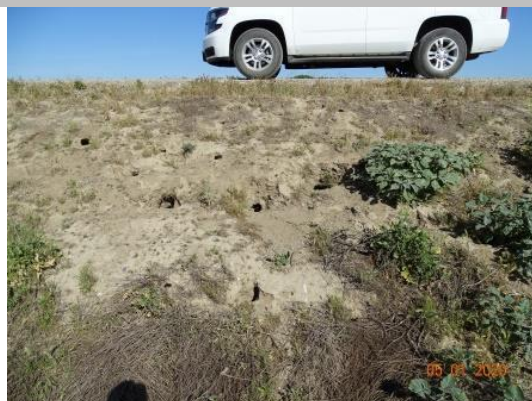
Photo 1 of 1 : SP_2022_NA0010_140_6_20220308_00001.jpg

LM Start	0.80	Rating **	M	Issue No.	6
LM End	0.84	Issue Type +	Ma	Location *	LS
Category	Earthen Levee			GPS Latitude/Longitude	
				Start	End
Item	Animal Control			36.766553 °	36.766962 °
				-120.278947 °	-120.278602 °
DWR ID	DWR_NA0010_24_s_2013_6				
Comment Code					
A1 : Exterminate rodents and backfill and compact or grout burrows.					
Inspector Comment					
There are several rodent holes identified within this section.

Rodent burrows in the landside slope. (Spring 2020)

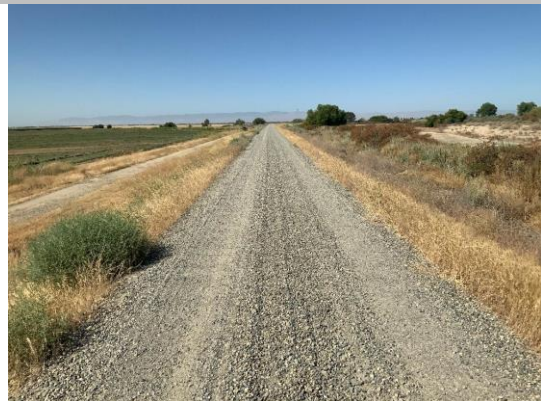
Photo 1 of 3 : UCIP_SP_2022_68916_102771.jpg

Comment Code					
Inspector Comment					
FS_ID:68916 DS_ID:19961 EP_NO: 13735 Repair Type: Non-Urgent Crossing Status: Found UCIP Comments: 07/20/2021 The record remains Non-Urgent. No pipe visible on LS or WS, only siphon breaker on slope and pump station found on the LS. Appears abandoned due to no discharge pipelines being visible and no steel cutoff wall or LS vent pipe present. Contact owner to confirm pipe alignment and status. No permit was found authorizing this encroachment. CVFPB will need to review crossing to determine owner. The UCIP inspection was completed with GEI staff, P. Espinoza. (H. Dunn ? GEI)04/08/2014 Unable to determine status of crossing. Need to contact owner to determine status of crossing. (O. Magana - DWR UCIP) FIELD_STRUCT_DESC: 24-inch coated steel drainage discharge pipe through the levee, 2 feet below the crown. Crown roadway has been padded 1 foot. Steel cutoff wall around the pipe at the centerline of the levee. Pump on the landside (LS). Siphon breaker on the apex of the pipe on the LS shoulder. Galvanized siphon vent pipe on the LS shoulder. (Plans to install two 24-inch steel discharge pipelines through the levee to dispose of seepage water collected in farm sumps Nos. 8 and 12 authorized under Permit No. 13735, 1983 - Rio Seco Farm). [Additional Reference(s): DWR Levee Log, 2002 (HLM 1.07), listed as a 24-inch steel pipe]. FS Date: 7/20/2021

Levee crown.

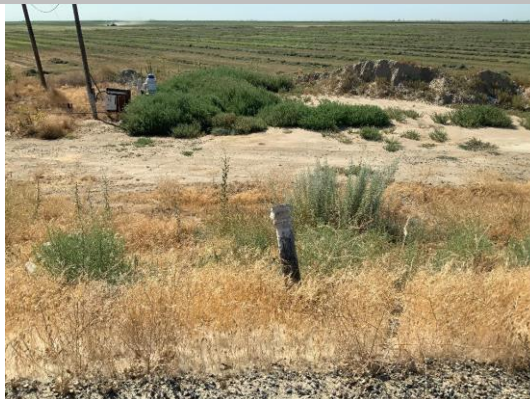
Photo 2 of 3 : UCIP_SP_2022_68916_102770.jpg

LS view: Siphon breaker visible on the slope from crown.

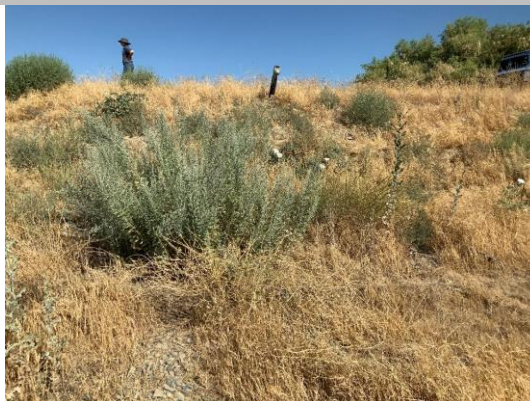
Photo 3 of 3 : UCIP_SP_2022_68916_102772.jpg

LS view: Slope from toe.

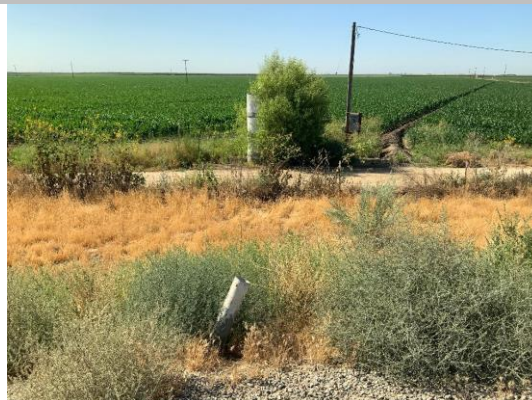
Photo 2 of 3 : UCIP_SP_2022_68917_102778.jpg

LS view: Small riser visible on the slope from the crown.

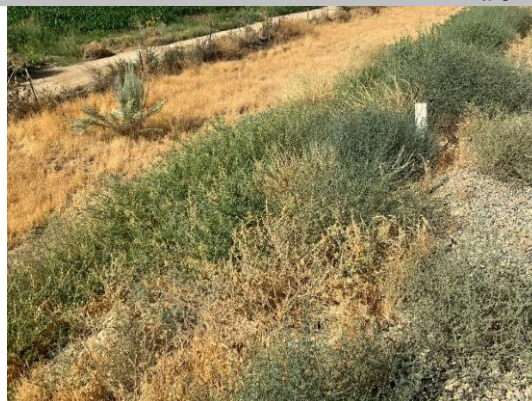
Photo 3 of 3 : UCIP_SP_2022_68917_102779.jpg

LS view: Slope from crown, no pipe visible.

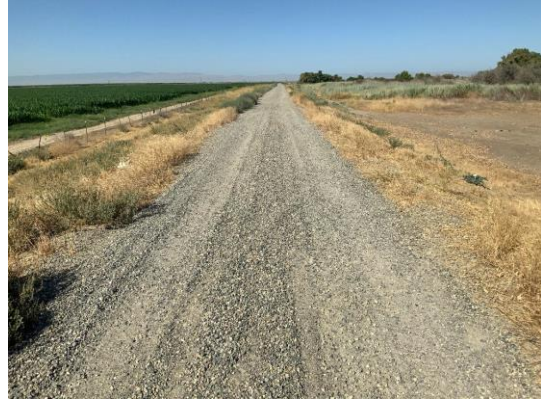
Photo 1 of 3 : UCIP_SP_2022_68918_102784.jpg

Comment Code					
Inspector Comment					
FS_ID:68918 DS_ID:19963 EP_NO: 13735 Repair Type: Non-Urgent Crossing Status: Indicator Found UCIP Comments: 07/20/2021 The record remains Non-Urgent. No pipe inlet or outlet found on WS or LS. Only siphon breaker on LS slope and well pump seen off the LS toe. Appears abandoned due to no actual pipe, cutoff wall, or vent pipe seen. Confirm with the owner on alignment and status of this pipe. The UCIP inspection was completed with GEI staff, P. Espinoza. (H. Dunn ? GEI) 04/08/2014 Unable to confirm status of crossing. (O. Magana - DWR UCIP) FIELD_STRUCT_DESC: 24-inch coated steel drainage discharge pipe through the levee, 2 feet below the crown. Crown roadway has been padded 1 foot. Steel cutoff wall around the pipe at the centerline of the levee. Pump on the landside (LS). Siphon breaker on the apex of the pipe on the LS shoulder. Galvanized siphon vent pipe on the LS shoulder. (Plans to install two 24-inch steel discharge pipelines through the levee to dispose of seepage water collected in farm sumps Nos. 8 and 12 authorized under Permit No. 13735, 1983 - Rio Seco Farm). [Additional Reference(s): DWR Levee Log, 2002 (HLM 2.68) listed as a 24-inch steel pipe]. FS Date: 7/20/2021

Levee crown.

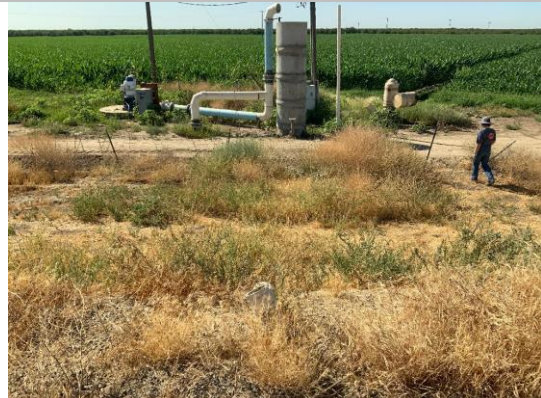
Photo 2 of 3 : UCIP_SP_2022_68918_102785.jpg

LS view: Siphon breaker visible on slope from crown.

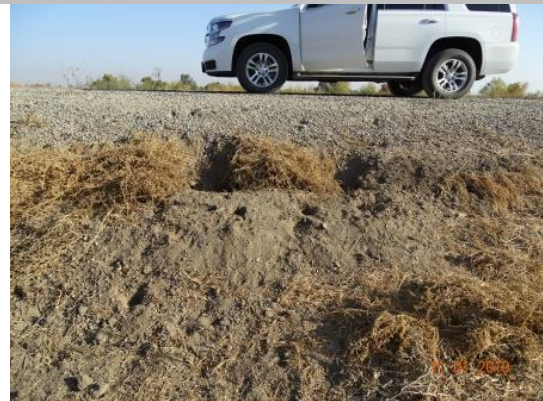
Overview of levee crown, looking US

**Flood Control Project Maintenance
Levee Inspections**

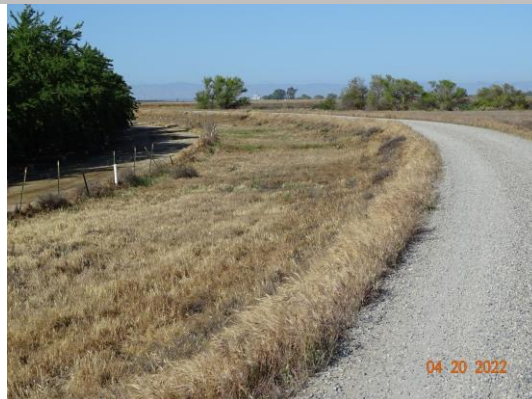
Photo 3 of 3 : UCIP_SP_2022_70698_90805.jpg

LM Start	15.82	Rating **	M	Issue No.	71 (cont)
LM End	15.82	Issue Type +	Ma	Location *

WS view: overview of WS

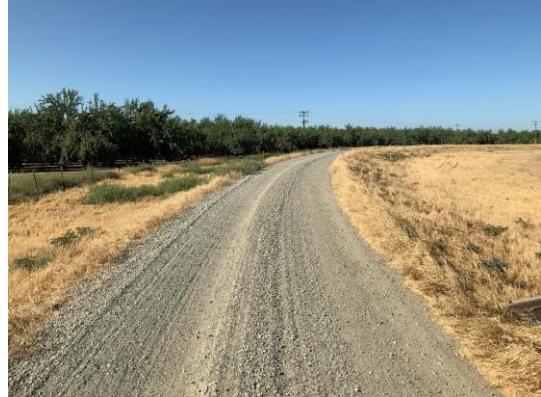
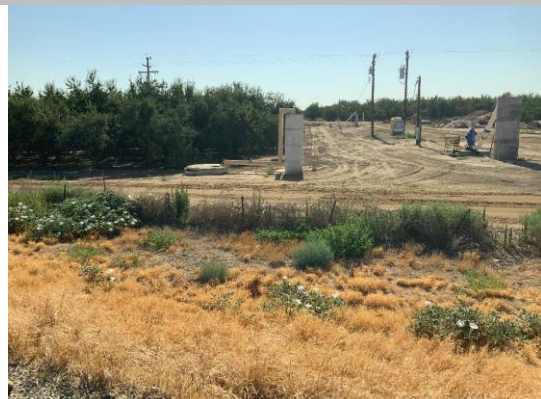
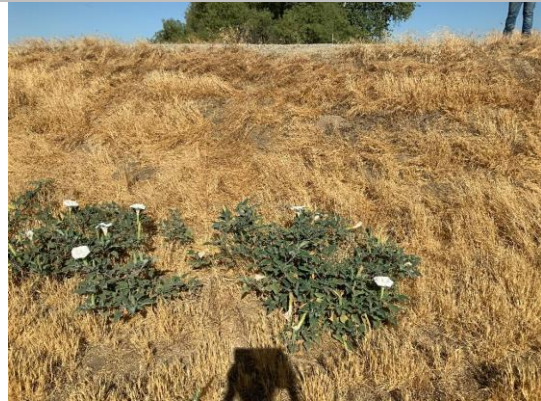
FS_ID:69550
DS_ID:19964
EP_NO: N/A
Repair Type: Non-Urgent
Crossing Status: Found
UCIP Comments: 07/20/2021 The record remains Non-Urgent. No inlet or outlet found on WS or LS. Slidegate found on WS slope and concrete riser visible off the LS toe. Appears abandoned, no pump attached. Confirm with owner on the alignment and status of this pipe. No permit was found authorizing this encroachment. CVFPB will need to review crossing to determine owner. The UCIP inspection was completed with GEI staff, P. Espinoza. (H. Dunn ? GEI) 04/08/2014 Unable to confirm crossing alignment and appurtenances associated with this crossing. Multiple stand pipes visible on landward side. Need to contact owner to determine status of crossing and alignment. (O. Magana - DWR UCIP)
FIELD_STRUCT_DESC: 30-inch by 30-inch square reinforced concrete box drainage discharge culvert through the levee, 12.5 feet below the crown. Pump on the landside (LS). Concrete riser with slide gate on the waterside (WS) slope. Screw gate on the LS shoulder. (Plans to construct a new discharge structure and to rehabilitate one existing diversion structure to return intercepted seepage to the San Joaquin River authorized under Permit No. 13085, 1981 - Diener, Dry River Farms). [Additional Reference(s): DWR Levee Log, 2002 (HLM 4.05), listed as a 30-inch square reinforced concrete box culvert (RCBC)].

LS view: Slope from toe, no pipe visible.

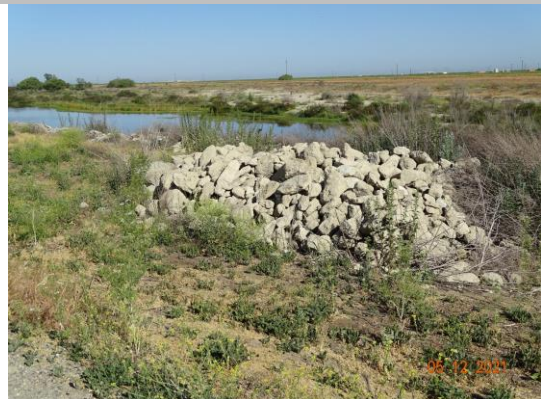
Overview of levee crown looking upstream towards pipe crossing.

Levee Inspection Report By Mile - Spring 2022

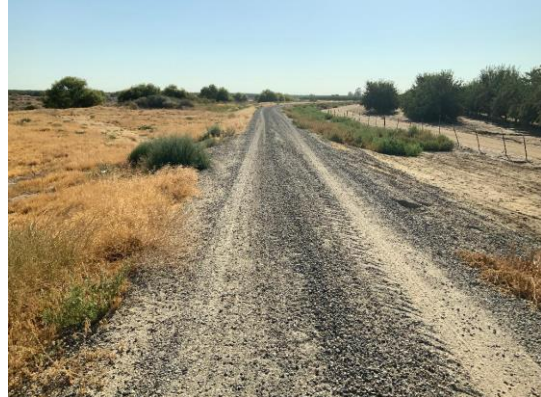
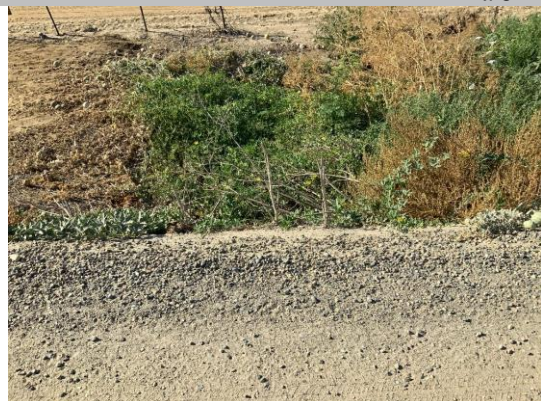
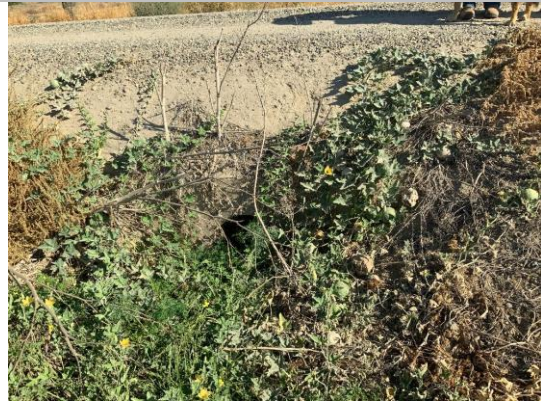
Comment Code						
Inspector Comment						
FS_ID:68920 DS_ID:19956 EP_NO: N/A Repair Type: Non-Urgent Crossing Status: Found UCIP Comments: 07/20/2021 The record has been upgraded from No Action Needed to Non-Urgent. Limited inspection due to some vegetation covering LS pipe inlet, recommend removal. No permit was found authorizing this encroachment. CVFPB will need to review crossing to determine owner. Levee prism appears less than 3 feet in height. The UCIP inspection was completed with GEI staff, P. Espinoza. (H. Dunn ? GEI) FIELD_STRUCT_DESC: 24-inch corrugated metal gravity drainage pipe through the levee, 5 feet below the crown. Flap gate on the waterside (WS) end. Concrete headwall on the landside (LS) end. Concrete U-shaped headwall on the WS end. [Additional Reference(s): DWR Levee Log, 2002 (HLM 6.09), listed as a 24-inch corrugated metal pipe (CMP)]. FS Date: 7/20/2021

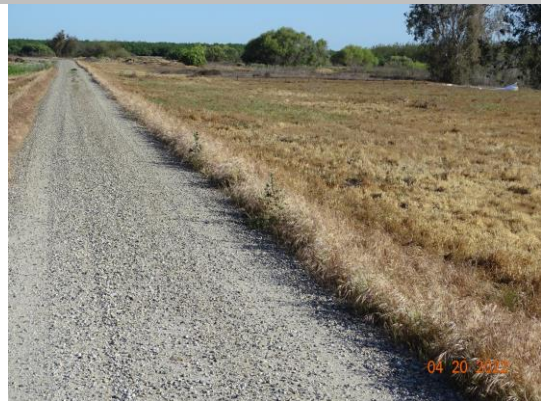
Waterway	Bank	Unit Miles	Inspection Start/End	Inspector
Unit No. 01 San Joaquin River	Right	22.52	04/05/2022 04/05/2022	Corey Fujitani

Lower San Joaquin Levee District

Photo 3 of 3 : UCIP_SP_2022_70701_90815.jpg
