**Flood Control Project Maintenance
Levee Inspections
LMA District Cover Sheet**

Lower San Joaquin Levee District

**Flood Control Project Maintenance
Levee Inspections
Unit Cover Sheet**

Levee Inspection Report By Mile - Spring 2022

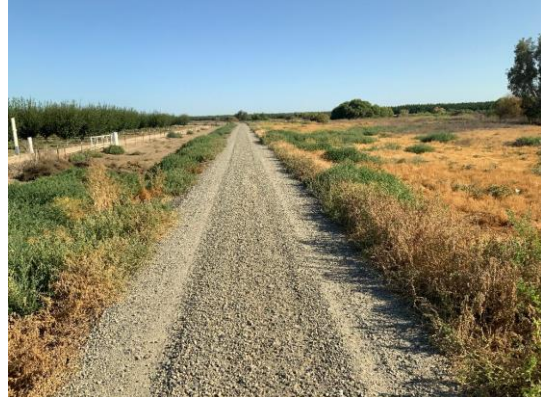
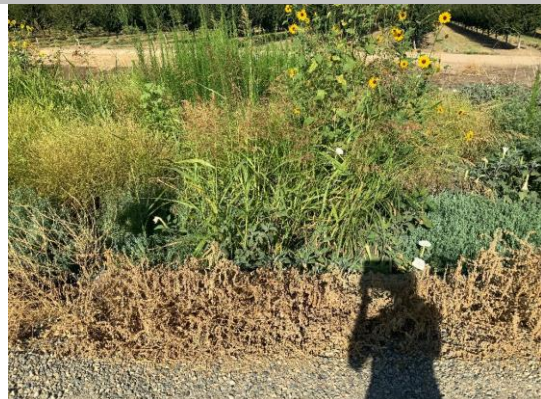
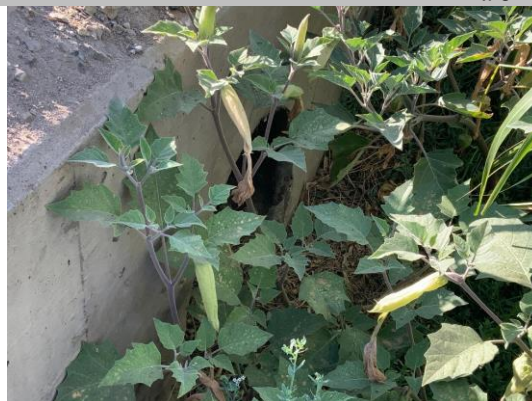
Comment Code						
Inspector Comment						
FS_ID:68922 DS_ID:19957 EP_NO: N/A Repair Type: Non-Urgent Crossing Status: Found UCIP Comments: 07/20/2021 The record remains Non-Urgent. Limited inspection due to some vegetation covering LS pipe inlet, recommend removal. No permit was found authorizing this encroachment. CVFPB will need to review crossing to determine owner. The levee prism appears to be less than 3 feet. The UCIP inspection was completed with GEI staff, P. Espinoza. (H. Dunn ? GEI) 7/20/2016 same as previous inspection. Crossing has been downgraded from Urgent to Non-Urgent PVC does not prevent WS flap gate from closing. (O. Magana - DWR UCIP)4/08/2014 Unauthorized PVC pipe through existig crossing. PVC distorted inside--Need to contact owner to correct issue. If crossing was allowed need to contact owner for permit number issue for crossing variance. (O. Magana - DWR UCIP) FIELD_STRUCT_DESC: 24-inch corrugated metal gravity drainage pipe through the levee, 3.6 feet below the crown. Flap gate on the waterside (WS) end. Concrete headwall on the landside (LS) end. Concrete U-shaped headwall on the WS end. [Additional Reference(s): DWR Levee Log, 2002 (HLM 6.72), listed as a 24-inch corrugated metal pipe (CMP)]. FS Date: 7/20/2021

LS view: Closeup of pipe inlet at toe with vegetation overgrowth.

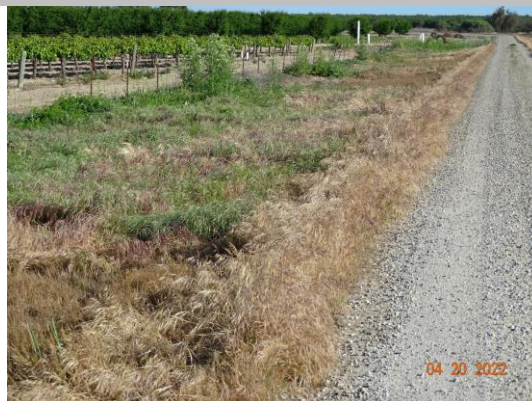
LM Start	17.01	Rating **	M	Issue No.	77	
LM End	17.01	Issue Type +	Ma	Location *		
Category	Supplemental			GPS Latitude/Longitude		
				Start	End	
Item	DWR UCIP LMA Responsibility			37.221838 °	37.221838 °	
				-120.780230 °	-120.780230 °	
DWR ID	19577

Waterway	Bank	Unit Miles	Inspection Start/End	Inspector
Unit No. 01 San Joaquin River	Right	22.52	04/05/2022 04/05/2022	Corey Fujitani

Photo 1 of 3 : UCIP_SP_2022_70704_90825.jpg

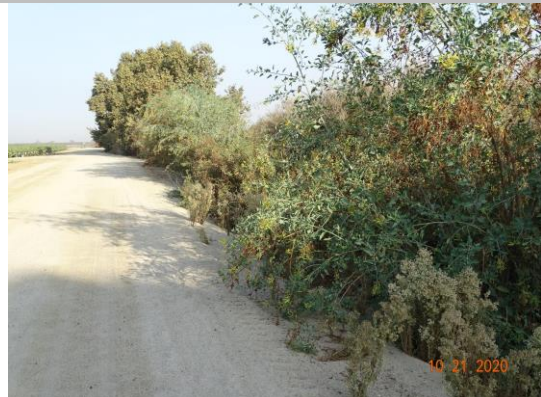
Comment Code

LM Start	17.19	Rating **	M	Issue No.	78
LM End	17.19	Issue Type +	Ma	Location *	
Category	Supplemental		GPS Latitude/Longitude		
			Start	End	
Item	DWR UCIP LMA Responsibility		37.219302 °	37.219302 °	
			-120.779475 °	-120.779475 °	
DWR ID	19578

FS_ID:70705
DS_ID:19578
EP_NO: N/A
Repair Type: Non-Urgent
Crossing Status: Found
UCIP Comments: 11/16/2020 Record remains Non-Urgent. No permit was found authorizing this encroachment. CVFPB will need to review crossing to determine owner. DWR DMP has not found internal issues, LOF between 1 and 2. Recommend inspection in 5 years. (B. Singh - GEI, O. Magana - DWR UCIP)04/25/2014 Dense vegetation limits the inspector's visibility to identify signs of pipe failure (leaks) along the waterward and landward slopes. Recommend removing vegetation along pipe alignment to conduct proper inspection of structure. Sediment buildup inside pipe visible from landward side. Recommend clearing pipe. (O. Magana - DWR UCIP)
FIELD_STRUCT_DESC: 24-inch corrugated metal (CM) gravity drainage pipe through the levee, 11.5 feet below the crown. Flap gate on the waterside (WS) end. Brass cap No. 50 bench mark (BM) on the headwall on the landside (LS). [Additional Reference(s): DWR Levee Log, 2002, (HLM 17.20). USACE San Joaquin O&M Manual, Unit No. 601, Part No. 1, (SJR601.1), 1967, Revised 25 May 2011, (HLM 17.19)].

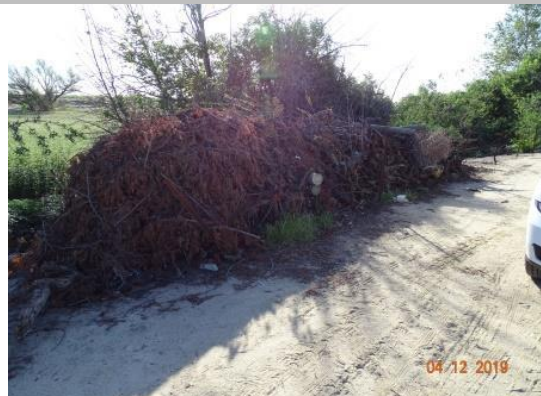
Photo 1 of 3 : UCIP_SP_2022_70705_93002.jpg

FS Date: 11/16/2020

Overview of levee crown looking upstream towards pipe crossing.

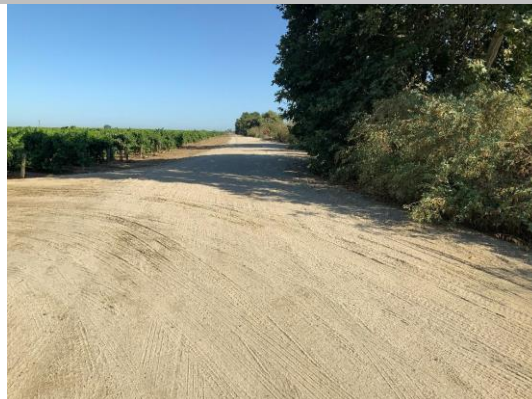
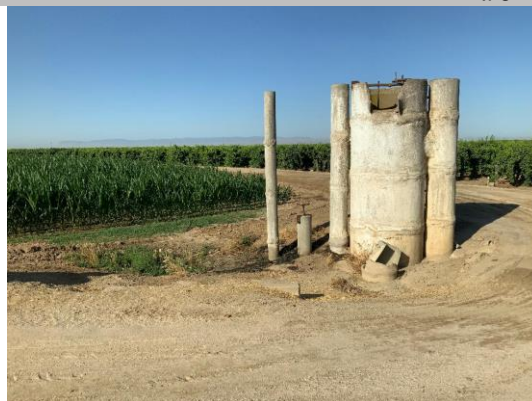
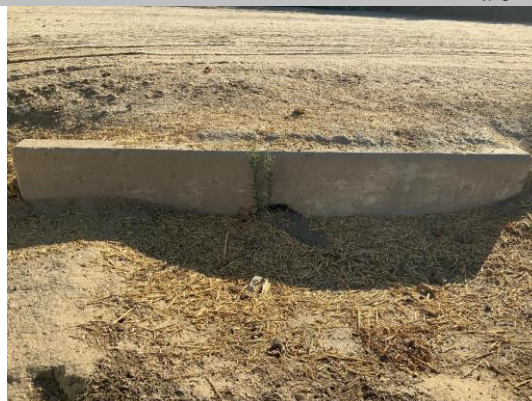
Comment Code					
Inspector Comment					
FS_ID:68923 DS_ID:19958 EP_NO: N/A Repair Type: Non-Urgent Crossing Status: Found UCIP Comments: 07/20/2021 The record has been upgraded from No Action Needed to Non-Urgent. Limited inspection due to LS pipe inlet covered by sediment and WS flapgate covered by vegetation debris, recommend clearing out both sides. Levee prism appears to be less than 3 feet in height. No permit was found authorizing this encroachment. CVFPB will need to review crossing to determine owner. The UCIP inspection was completed with GEI staff, P. Espinoza. (H. Dunn ? GEI) FIELD_STRUCT_DESC: 12-inch corrugated metal gravity drainage pipe through the levee, 2.5 feet below the crown. Flap gate on the waterside (WS) end. Concrete headwall on each end. [Additional Reference(s): DWR Levee Log, 2002 (HLM 7.63), listed as a 12-inch corrugated metal pipe (CMP)]. FS Date: 7/20/2021

LS view: Headwall just visible at toe from crown.

LS view: Headwall and slope from toe.

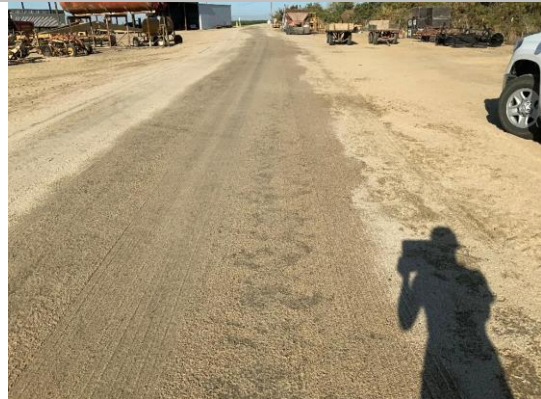
Photo 1 of 3 : UCIP_SP_2022_69551_102857.jpg

Comment Code						
Inspector Comment						
FS_ID:69551 DS_ID:19959 EP_NO: N/A Repair Type: Non-Urgent Crossing Status: Indicator Found UCIP Comments: 07/20/2021 The record is Non-Urgent. Possible WS headwall visible from the crown but inaccessible due to fences, limited inspection. Appears removed or abandoned due to no cobble outlet channel or outlet visible on the LS. LS end is completely flat and adjacent to a working farm. DWR DMP geophysical study did not confirm presence of pipe through levee. Record will remain in UCIP's inspection records until future Levee Improvement Project can confirm no crossing was found through the levee. No permit was found authorizing this encroachment. CVFPB will need to review crossing to determine owner. Levee prism appears to be less than 3 feet in height. The UCIP inspection was completed with GEI staff, P. Espinoza. (H. Dunn ? GEI) FIELD_STRUCT_DESC: 36-inch reinforced concrete gravity drainage pipe through the levee, 10.5 feet below the crown. Flap gate on the waterside (WS) end. Concrete headwall on the WS end. 10-foot cobble revetted outlet channel. [Additional Reference(s): DWR Levee Log, 2002 (HLM 8.16), listed as a 36-inch concrete pipe. USACE San Joaquin O&M Manual, Unit 601 Part 1 (SJR601.1), 1967, Revised 25 May 2011, (HLM 8.15), listed as a 36-inch concrete pipe]. FS Date: 7/20/2021

Levee crown.

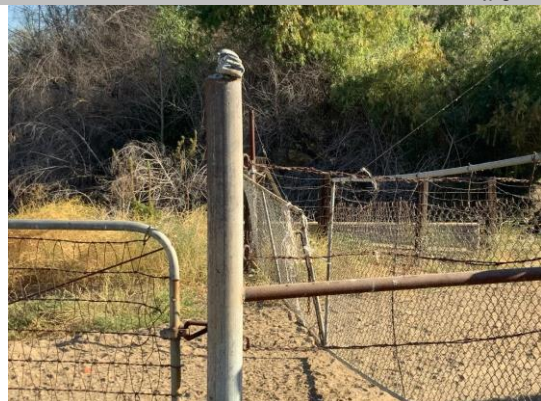
Photo 2 of 3 : UCIP_SP_2022_69551_102856.jpg

LS view: Top of a headwall barely visible behind fences from crown.

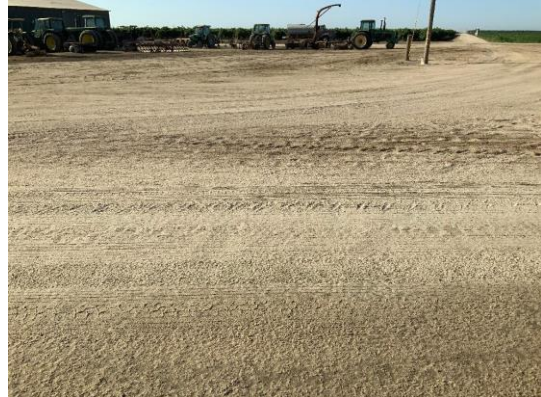
Photo 3 of 3 : UCIP_SP_2022_69551_102858.jpg

WS view: Toe from crown, no pipe visible.

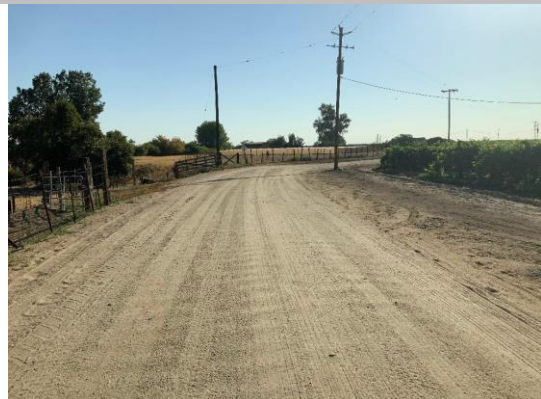
Photo 1 of 3 : UCIP_SP_2022_68925_102859.jpg

FS_ID:68925
 DS_ID:19960
 EP_NO: N/A
 Repair Type: Non-Urgent
 Crossing Status: Found
 UCIP Comments: 07/20/2021 The record remains Non-Urgent. WS outlet filled with sediment, recommend cleaning out. LS pipe inlet not found, likely buried under dirt, recommend removal. No permit was found authorizing this encroachment. CVFPB will need to review crossing to determine owner. Levee prism appears to be less than 3 feet in height. The UCIP inspection was completed with GEI staff, P. Espinoza. (H. Dunn ? GEI) 04/08/2014 Barbed wire along levee shoulder--no access. Need to confirm crossing size and condition of crossing. (O. Magana - DWR UCIP)
 FIELD_STRUCT_DESC: 12-inch reinforced concrete gravity drainage pipe through the levee, 3 feet below the crown. Flap gate on the waterside (WS) end. Concrete headwall on the WS end. [Additional Reference(s): DWR Levee Log, 2002 (HLM 8.33), listed as a 12-inch concrete pipe. USACE San Joaquin O&M Manual, Unit 601 Part 1 (SJR601.1), 1967, Revised 25 May 2011, (HLM 8.32), listed as a 12-inch concrete pipe]

Levee crown.

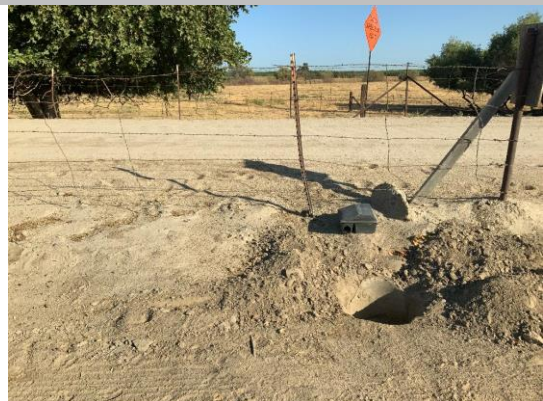
Photo 3 of 3 : UCIP_SP_2022_68925_102864.jpg

LS view: Slope from toe, no pipe visible.

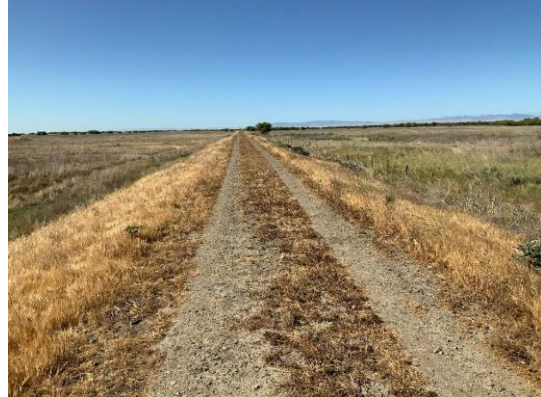
Photo 1 of 3 : UCIP_SP_2022_68238_100680.jpg

Comment Code						
Inspector Comment						
FS_ID:68238 DS_ID:19965 EP_NO: N/A Repair Type: Non-Urgent Crossing Status: Found UCIP Comments: 06/8/2021 The record remains Non-Urgent. Landside (LS) pipe inlet has some vegetation and sediment buildup, recommend cleaning out. No permit was found authorizing this encroachment. CVFPB will need to review crossing to determine owner. The UCIP inspection was completed with GEI staff, P. Espinoza. (H. Dunn ? GEI) 05/01/2014 Dense vegetation limits the inspectors visibility to identify signs of pipe failure (leaks) along the slope. Recommend removing vegetation along pipe alignment to conduct proper inspection of structure. Sediment buildup in pipe visible from landward side-- recommend clearing. (O. Magana - DWR UCIP) FIELD_STRUCT_DESC: 24-inch corrugated metal gravity drainage pipe through the levee, 10 feet below the crown. Flap gate on the waterside (WS) end. [Additional Reference(s): DWR Levee Log, 2002 (HLM 0.01), listed as a 24-inch corrugated metal pipe (CMP). USACE San Joaquin O&M Manual, Unit 601 Part 1 (SJR601.1), 1967, Revised 25 May 2011, (HLM 0.02), listed as a 24-inch CMP] FS Date: 6/8/2021

Levee crown looking upstream.

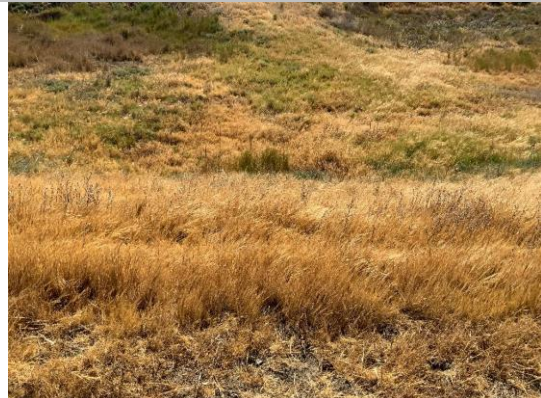
Photo 2 of 3 : UCIP_SP_2022_68238_100681.jpg

LS view: Toe from crown.

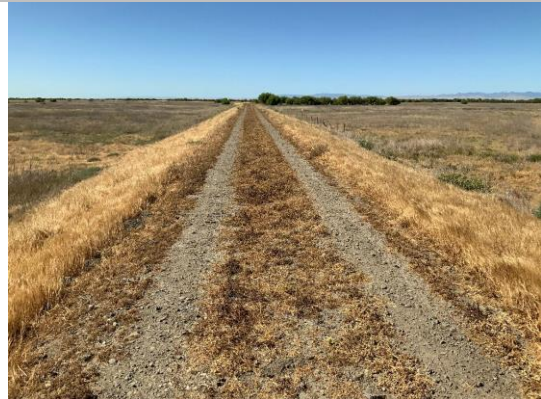
Photo 1 of 3 : UCIP_SP_2022_68240_100698.jpg

FS_ID:68240
DS_ID:19966
EP_NO: N/A
Repair Type: Non-Urgent
Crossing Status: Found
UCIP Comments: 06/8/2021 The record remains Non-Urgent. Dense LS vegetation over pipe inlet and headwall, recommend removal. No permit was found authorizing this encroachment. CVFPB will need to review crossing to determine owner. The UCIP inspection was completed with GEI staff, P. Espinoza. (H. Dunn ? GEI) 05/01/2014 Dense vegetation limits the inspectors visibility to identify signs of pipe failure (leaks) along the slope. Recommend removing vegetation along pipe alignment to conduct proper inspection of structure. (O. Magana - DWR UCIP)
FIELD_STRUCT_DESC: 24-inch corrugated metal gravity drainage pipe through the levee, 11.6 feet below the crown. Flap gate on the waterside (WS) end. [Additional Reference(s): DWR Levee Log, 2002 (HLM 0.36), listed as a 24-inch corrugated metal pipe (CMP). USACE San Joaquin O&M Manual, Unit 601 Part 1 (SJR601.1), 1967, Revised 25 May 2011, (HLM 0.35), listed as a 24-inch CMP].

Levee crown looking upstream.

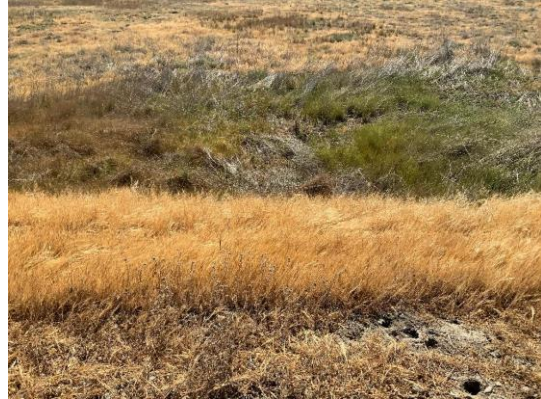
Photo 2 of 3 : UCIP_SP_2022_68240_100699.jpg

LS view: Toe from crown.

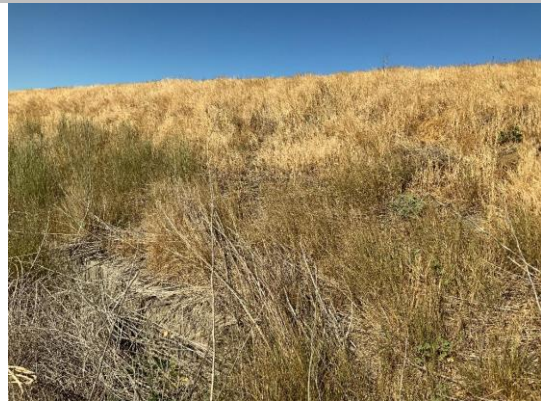
Photo 3 of 3 : UCIP_SP_2022_68240_100700.jpg

LS view: Slope from toe.

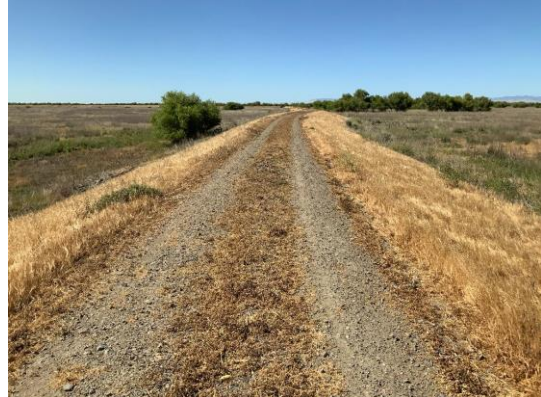
Photo 1 of 3 : UCIP_SP_2022_67743_100705.jpg

Comment Code					
Inspector Comment					
FS_ID:67743 DS_ID:19967 EP_NO: N/A Repair Type: Non-Urgent Crossing Status: Found UCIP Comments: 06/8/2021 The record remains Non-Urgent. Dense LS vegetation, recommend removal around pipe inlet. No permit was found authorizing this encroachment. CVFPB will need to review crossing to determine owner. The UCIP inspection was completed with GEI staff, P. Espinoza. (H. Dunn ? GEI) 05/01/2014 Dense vegetation limits the inspectors visibility to identify signs of pipe failure (leaks) along the slope. Recommend removing vegetation along pipe alignment to conduct proper inspection of structure. (O. Magana - DWR UCIP) FIELD_STRUCT_DESC: 24-inch corrugated metal gravity drainage pipe through the levee, 14.7 feet below the crown. Flap gate on the waterside (WS) end. [Additional Reference(s): DWR Levee Log, 2002 (HLM 0.58), listed as a 24-inch corrugated metal pipe (CMP). USACE San Joaquin O&M Manual, Unit 601 Part 1, (SJR601.1), 1967, Revised 25 May 2011, (HLM 0.59), listed as a 24-inch CMP]. FS Date: 6/8/2021

Levee crown looking upstream.

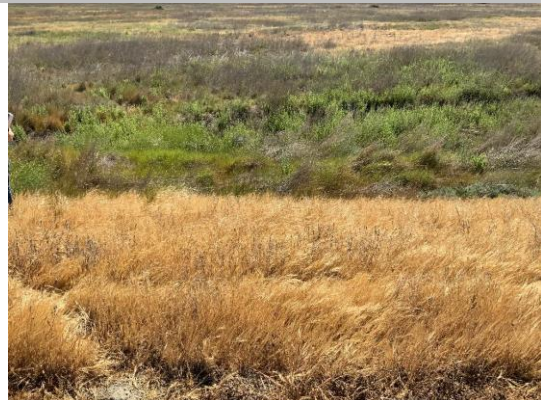
Photo 2 of 3 : UCIP_SP_2022_67743_100710.jpg

LS view: Toe from crown.

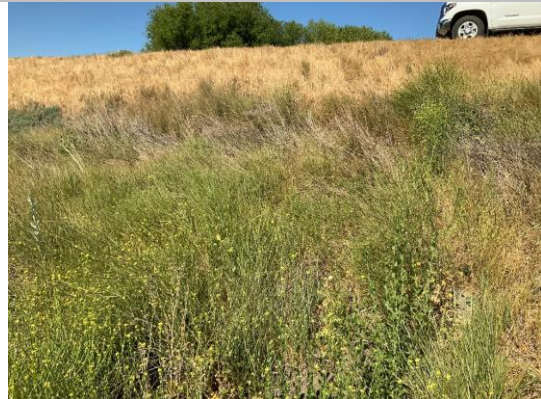
Photo 3 of 3 : UCIP_SP_2022_67743_100703.jpg

LS view: Slope from toe.

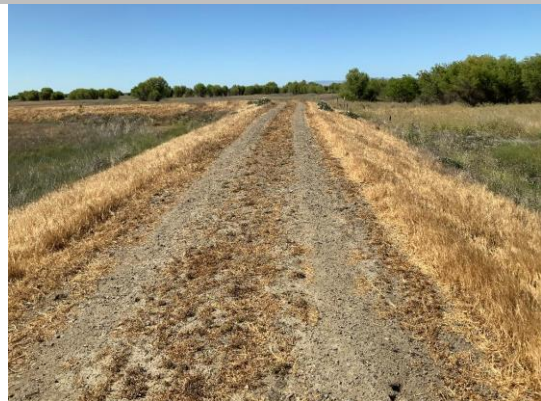
Photo 1 of 3 : UCIP_SP_2022_67745_100717.jpg

FS_ID:67745
DS_ID:19968
EP_NO: N/A
Repair Type: Non-Urgent
Crossing Status: Found
UCIP Comments: 06/8/2021 The record remains Non-Urgent. Dense LS vegetation over pipe inlet, recommend removal. Lots of small burrow holes all along the crown and along the sides, recommend filling in. No permit was found authorizing this encroachment. CVFPB will need to review crossing to determine owner. The UCIP inspection was completed with GEI staff, P. Espinoza. (H. Dunn ? GEI) 05/01/2014 Dense vegetation limits the inspectors visibility to identify signs of pipe failure (leaks) along the slope. Recommend removing vegetation along pipe alignment to conduct proper inspection of structure. (O. Magana - DWR UCIP)
FIELD_STRUCT_DESC: 24-inch corrugated metal gravity drainage pipe through the levee, 11.4 feet below the crown. Flap gate on the waterside (WS) end. [Additional Reference(s): DWR Levee Log, 2002 (HLM 0.97), listed as a 24-inch corrugated metal pipe (CMP). USACE San Joaquin O&M Manual, Unit 601 Part 1 (SJR601.1), 1967, Revised 25 May 2011, (HLM 0.97), listed as a 24-inch CMP]

Levee crown looking downstream.

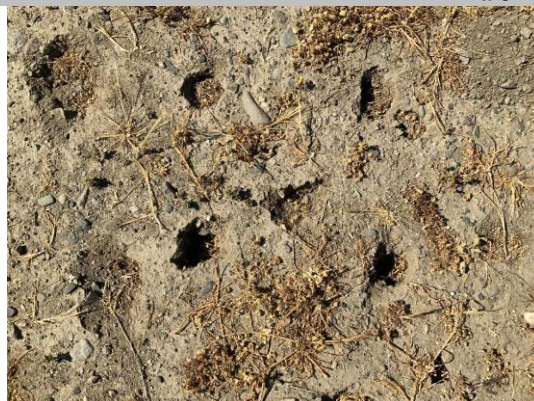
Photo 2 of 3 : UCIP_SP_2022_67745_100718.jpg

Crown: Small burrow holes along the crown, 1 of 2 photos.

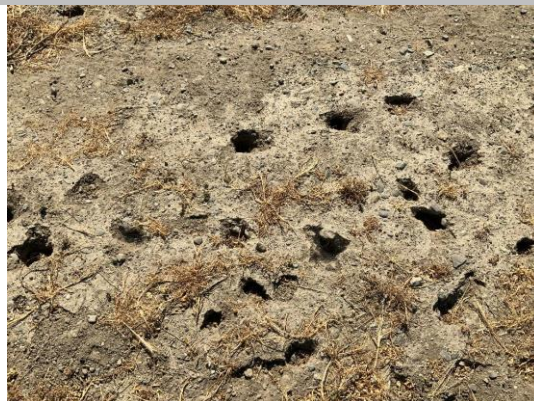
Photo 3 of 3 : UCIP_SP_2022_67745_100716.jpg

Crown: Small burrow holes on the top of the levee, 2 of 2 photos.

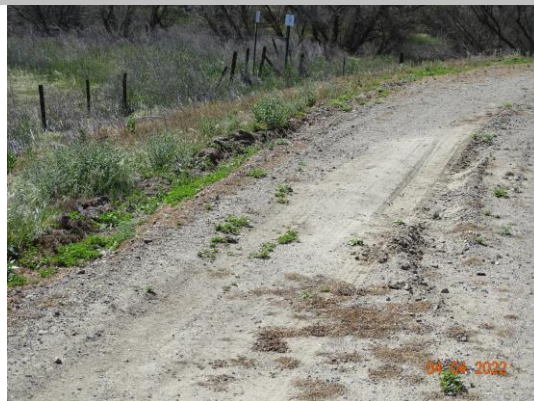
Photo 1 of 1 : SP_2022_NA0010_141_8_20220411_00019.jpg

LM Start	1.02	Rating **	M	Issue No.	8
LM End	1.02	Issue Type +	Ma	Location *	WS
Category	Earthen Levee			GPS Latitude/Longitude	
				Start	End
Item	Erosion / Vehicle Traffic			37.281710 °	37.281710 °
				-120.880523 °	-120.880523 °
DWR ID	DWR_NA0010_25_s_2022_8				
Comment Code					
E6 : Repair the levee slope damaged by vehicle traffic and prevent access where possible.					
Inspector Comment

View of rutting from vehicle traffic on the levee crown. (Spring 2022)

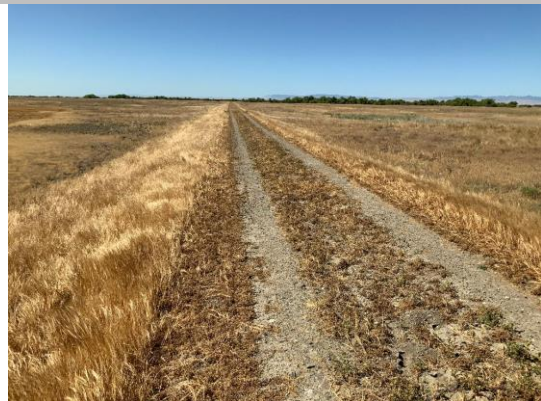
Photo 1 of 3 : UCIP_SP_2022_67747_100729.jpg

Comment Code						
Inspector Comment						
FS_ID:67747 DS_ID:19969 EP_NO: N/A Repair Type: Non-Urgent Crossing Status: Found UCIP Comments: 06/8/2021 The record remains Non-Urgent. Levee prism appears to be around or slightly less than 3 feet. Dense vegetation on LS pipe inlet, recommend removal. No permit was found authorizing this encroachment. CVFPB will need to review crossing to determine owner. The UCIP inspection was completed with GEI staff, P. Espinoza. (H. Dunn ? GEI) 05/01/2014 Dense vegetation limits the inspectors visibility to identify signs of pipe failure (leaks) along the slope. Recommend removing vegetation along pipe alignment to conduct proper inspection of structure. (O. Magana - DWR UCIP) FIELD_STRUCT_DESC: 24-inch corrugated metal gravity drainage pipe through the levee, 4 feet below the crown. Flap gate on the waterside (WS) end. [Additional Reference(s): DWR Levee Log, 2002 (HLM 2.05), listed as a 24-inch corrugated metal pipe (CMP). USACE San Joaquin O&M Manual, Unit 601 Part 1 (SJR601.1), 1967, Revised 25 May 2011, (HLM 2.05), listed as a 24-inch CMP] FS Date: 6/8/2021

Levee crown looking upstream.

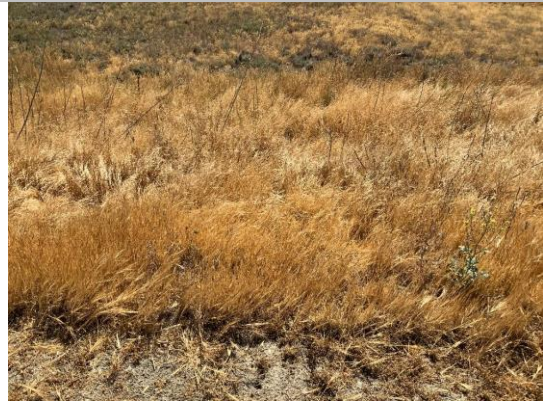
Photo 2 of 3 : UCIP_SP_2022_67747_100730.jpg

LS view: Toe from crown.

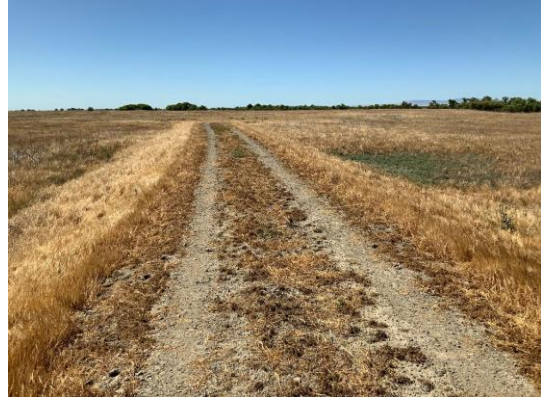
Photo 1 of 3 : UCIP_SP_2022_68241_100735.jpg

FS_ID:68241
DS_ID:19970
EP_NO: N/A
Repair Type: Urgent
Crossing Status: Found
UCIP Comments: 06/8/2021 Record has been upgraded from Non-Urgent to Urgent. External inspection in the field has found pipe integrity issues. WS pipe end is rusted with multiple large deteriorated holes under and around the flapgate. Rusting and peeling of metal and liner inside the LS pipe inlet. Also sediment buildup inside LS inlet, recommend cleaning out and recommend monitoring crossing until funding becomes available to address the issues. No permit was found authorizing this encroachment. CVFPB will need to review crossing to determine owner. The UCIP inspection was completed with GEI staff, P. Espinoza. (H. Dunn ? GEI)05/01/2014 Dense vegetation limits the inspectors visibility to identify signs of pipe failure (leaks) along the slope. Recommend removing vegetation along pipe alignment to conduct proper inspection of structure. Sediment buildup in pipe visible on landward side--recommend clearing. (O. Magana - DWR UCIP)

Levee crown looking upstream.

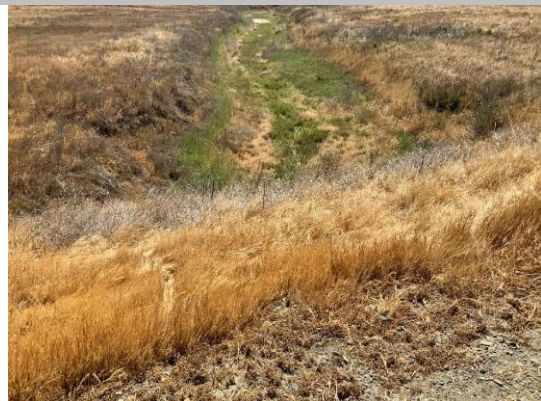
Photo 2 of 3 : UCIP_SP_2022_68241_100736.jpg

LS view: Toe from crown.
