Flood Control Project Maintenance
Levee Inspections
LMA District Cover Sheet

Lower San Joaquin Levee District

**Flood Control Project Maintenance
Levee Inspections
Unit Cover Sheet**

Levee Inspection Report By Mile - Spring 2024

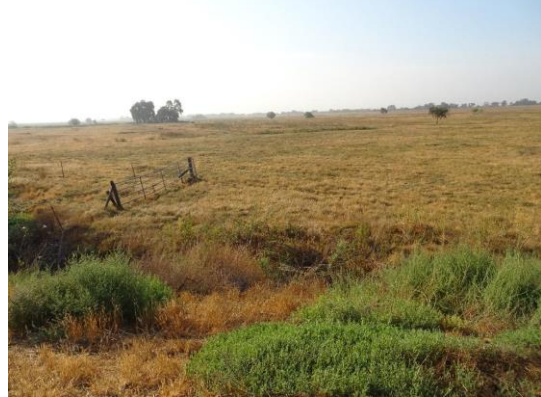
Photo 2 of 3 : UCIP_SP_2024_70636_92088.jpg

LS view: overview of LS, dense vegetation on slope and levee toe.

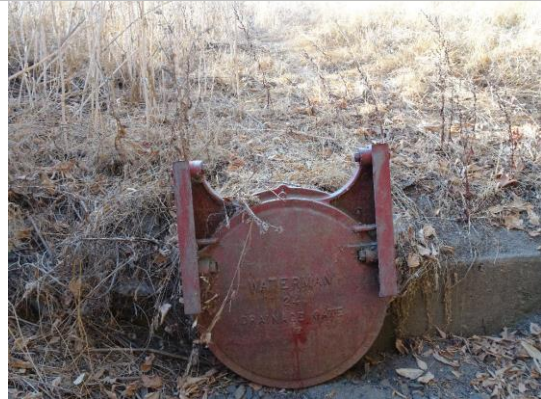
Photo 3 of 3 : UCIP_SP_2024_70636_92089.jpg

WS view: gate visible on the WS toe with concrete concrete wall supporting pipe.

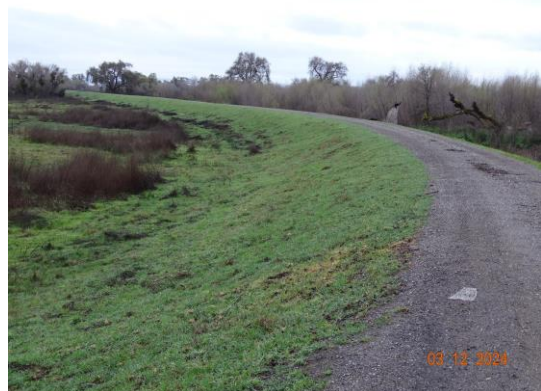
Photo 1 of 1 : SP_2024_NA0010_118_88_20240326_00256.jpg

LM Start	0.01	Rating **	A	Issue No.	88
LM End	0.01	Issue Type +	Ma	Location *	LS
Category	Earthen Levee			GPS Latitude/Longitude	
				Start	End
Item	Vegetation			37.348608 °	37.348608 °
				-120.959015 °	-120.959015 °
DWR ID	DWR_NA0010_01_s_2024_88				
Comment Code					
V1 : Control annual grass and weeds on the levee slopes and easements.					
Inspector Comment

View of the landside slope looking upstream. (Spring 2024)

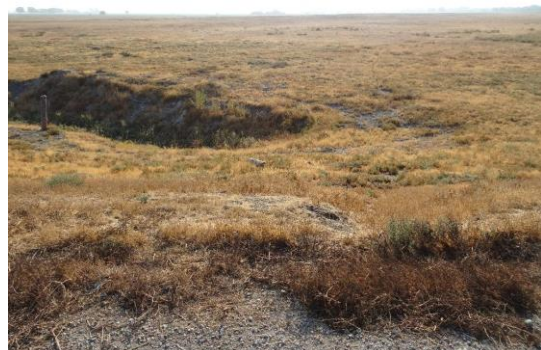
Photo 2 of 3 : UCIP_SP_2024_70637_90530.jpg

LS view: Overview of LS from levee crest, looking US

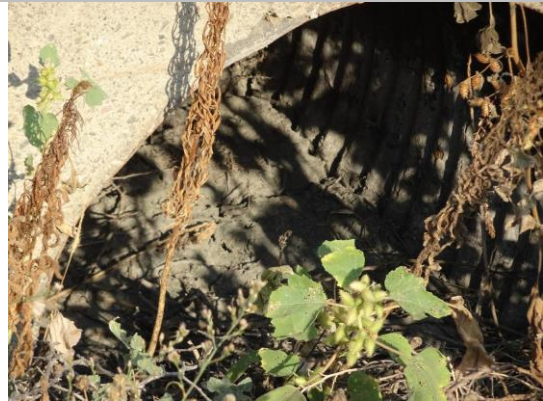
Photo 3 of 3 : UCIP_SP_2024_70637_92300.jpg

LS view: sediment build up along the pipe invert.

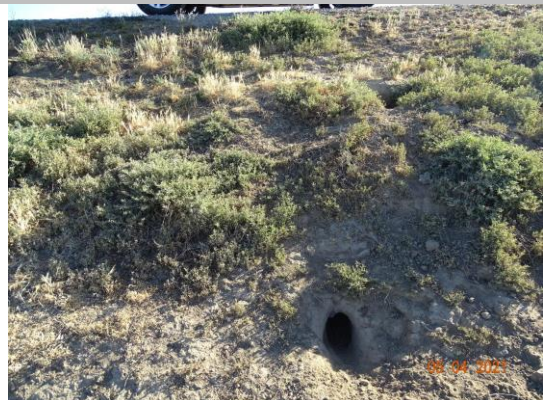
Photo 1 of 1 : SP_2024_NA0010_118_97_20240212_00006.jpg

LM Start	0.45	Rating **	M	Issue No.	97
LM End	0.45	Issue Type +	Ma	Location *	WS
Category	Earthen Levee			GPS Latitude/Longitude	
				Start	End
Item	Animal Control			37.343243°	37.343243°
				-120.962159°	-120.962159°
DWR ID	DWR_NA0010_01_s_2021_97				
Comment Code					
A1 : Exterminate rodents and backfill and compact or grout burrows.					
Inspector Comment

View of rodent burrows in the waterside slope. (Spring 2021)

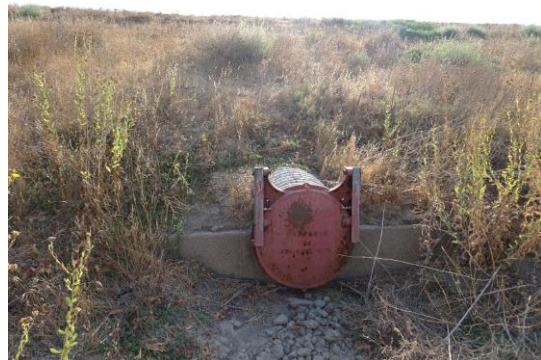
Photo 2 of 3 : UCIP_SP_2024_83224_90535.jpg

WS view: Flapgate and headwall at WS toe

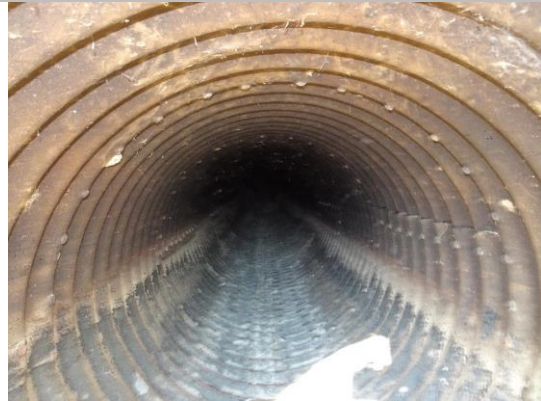
Photo 3 of 3 : UCIP_SP_2024_83224_90540.jpg

LS view: Inside pipe from LS toe

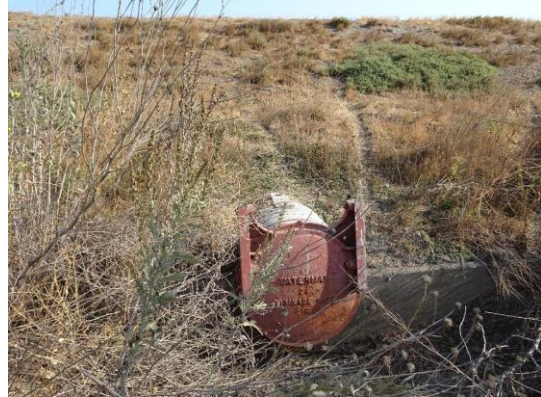
Photo 2 of 3 : UCIP_SP_2024_70639_90546.jpg

WS view: Pipe, flapgate, and headwall at WS toe

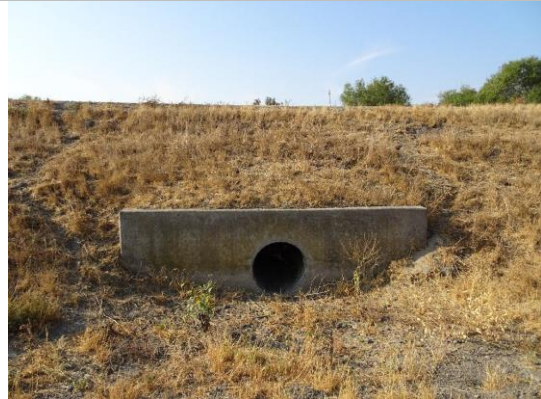
Photo 3 of 3 : UCIP_SP_2024_70639_90544.jpg

LS view: Pipe and headwall at LS toe

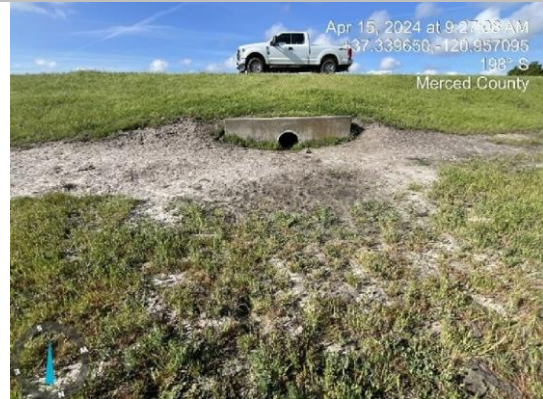
Photo 1 of 3 : UCIP_SP_2024_83233_121598.jpg

Comment Code						
Inspector Comment						
DS_ID:19585 FS_ID:83233 EP_NO: N/A Repair Type: No Action Needed EVAL Issue: Crossing Status: Found UCIP Comments: 04/23/2024 Record updated from Urgent to No Action Needed. The scour noted from previous inspection behind the concrete headwall on the LS toe has been corrected by the LMA. DMP internal video inspection has found none or minor pipe defects. (M. Thao - DWR UCIP) 12/19/2022 Record remains Urgent. Pipe has been CIPP-lined. LOF of crossing is less or equal to 4. Recommend next video inspection in 5 years. Scour behind the concrete headwall on the LS toe needs repair. (O. Yakimov - DWR UCIP) 10/06/2020 Record has been updated from Non-Urgent to Urgent. DWR DMP has found integrity issues, LOF between 5 and 6. Scour visible behind the concrete headwall on the LS toe. Recommend monitoring crossing until funding becomes available to addressed. No permit was found authorizing this encroachment. CVFPB will need to review crossing to determine owner. (B. Singh - GEI, O. Magana - DWR UCIP) 04/08/2014 Moderate erosion around headwall on landward toe. May or may not be an issue. Need to contact owner to determine status of crossing and to address erosion issue on landward side. (W. Wylie - DWR UCIP) FIELD_STRUCT_DESC: 24-inch CIPP-lined corrugated metal (CM) gravity drainage pipe through the levee, 9.0 feet below the crown. Flap gate on the waterside (WS) end. Brass cap No. 108 bench mark (BM) on the headwall on the landside (LS). [Additional Reference(s): DWR Levee Log, 2002, (HLM 0.96). USACE San Joaquin O&M Manual, Unit No. 601, Part No. 1, (SJR601.1), 1967, Revised 25 May 2011, (HLM 0.95)]. FS Date: 10/6/2020 4:21:36 PM

LS view: Headwall and pipe on LS toe. Scour surrounding headwall has been addressed (photo sent by LMA).

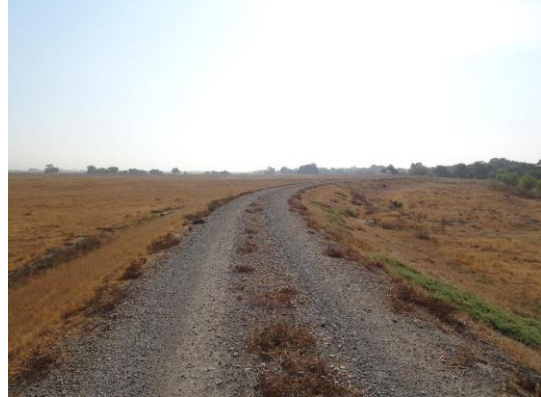
Photo 2 of 3 : UCIP_SP_2024_83233_90550.jpg

Overview of levee crown, looking US

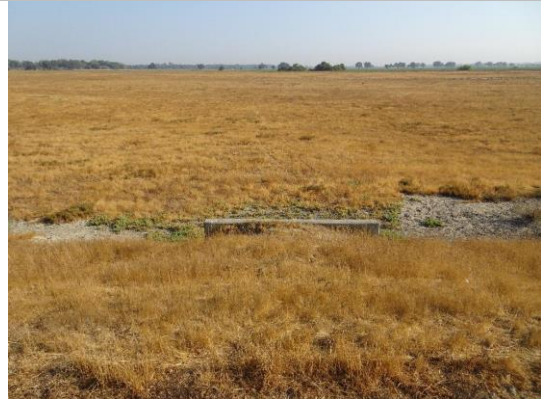
Photo 3 of 3 : UCIP_SP_2024_83233_90552.jpg

LS view: Headwall visible on LS toe

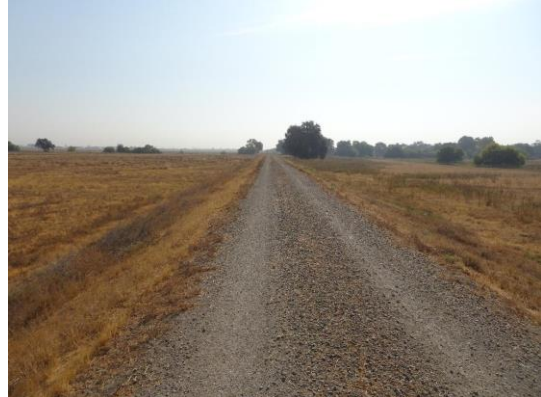
Photo 1 of 3 : UCIP_SP_2024_83235_90554.jpg

Comment Code					
Inspector Comment					
DS_ID:19586 FS_ID:83235 EP_NO: N/A Repair Type: No Action Needed EVAL Issue: Crossing Status: Found UCIP Comments: 04/23/2024 Record updated from Non-Urgent to No Action Needed. DMP internal video inspection has found none or minor pipe defects. (M. Thao - DWR UCIP) 10/06/2020 Record has been updated from No Action Needed to Non-Urgent. No permit was found authorizing this encroachment. CVFPB will need to review crossing to determine owner. DWR DMP has not found internal issues, LOF between 1 and 2. Recommend inspection in 5 years. (B. Singh - GEI, O. Magana - DWR UCIP) FIELD_STRUCT_DESC: 24-inch corrugated metal (CM) gravity drainage pipe through the levee, 7.5 feet below the crown. Flap gate on the waterside (WS) end. Brass cap No. 108 bench mark (BM) on the headwall on the landside (LS). [Additional Reference(s): DWR Levee Log, 2002, (HLM 1.18). USACE San Joaquin O&M Manual, Unit No. 601, Part No. 1, (SJR601.1), 1967, Revised 25 May 2011, (HLM 1.17)]. FS Date: 10/6/2020

Overview of levee crown, looking US

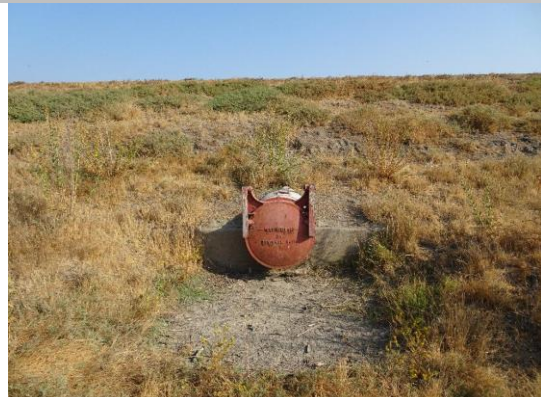
Photo 2 of 3 : UCIP_SP_2024_83235_90553.jpg

Pipe, flapgate and headwall on WS toe

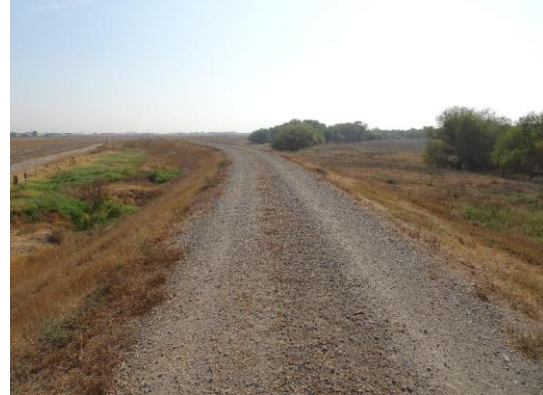
Photo 1 of 3 : UCIP_SP_2024_83238_90567.jpg

Comment Code						
Inspector Comment						
DS_ID:19588 FS_ID:83238 EP_NO: N/A Repair Type: No Action Needed EVAL Issue: Crossing Status: Found UCIP Comments: 04/23/2024 Record updated from Non-Urgent to No Action Needed. DMP internal video inspection has found none or minor pipe defects. (M. Thao - DWR UCIP) 10/06/2020 Record remains Non-Urgent. No permit was found authorizing this encroachment. CVFPB will need to review crossing to determine owner. DWR DMP has not found internal issues, LOF between 1 and 2. Recommend inspection in 5 years. (B. Singh - GEI, O. Magana - DWR UCIP) 04/08/2014 Some sediment buildup inside pipe at LS toe. Recommend contacting owner to clear sediment buildup and check wall integrity through pipe section. (W. Wylie - DWR UCIP) FIELD_STRUCT_DESC: 24-inch corrugated metal (CM) gravity drainage pipe through the levee, 11.0 feet below the crown. Flap gate on the waterside (WS) end. Brass cap No. 108 bench mark (BM) on the headwall on the landside (LS). [Additional Reference(s): DWR Levee Log, 2002, (HLM 1.48). USACE San Joaquin O&M Manual, Unit No. 601, Part No. 1, (SJR601.1), 1967, Revised 25 May 2011, (HLM 1.48)]. FS Date: 10/6/2020

Overview of levee crown, looking US

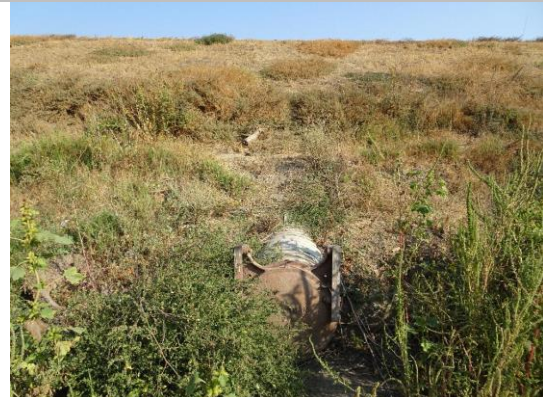
Photo 2 of 3 : UCIP_SP_2024_83238_90570.jpg

Pipe and flapgate visible on WS toe

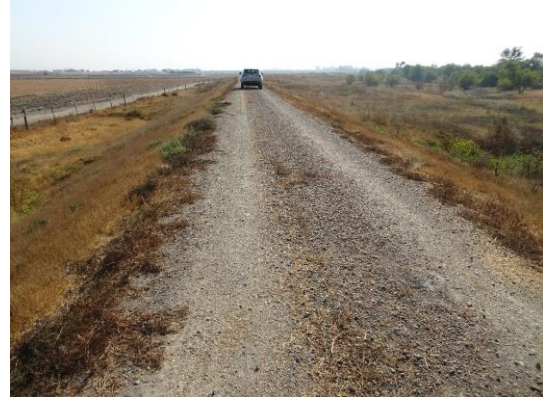
Photo 1 of 3 : UCIP_SP_2024_70644_90572.jpg

Comment Code					
Inspector Comment					
DS_ID:19589 FS_ID:70644 EP_NO: N/A Repair Type: No Action Needed EVAL Issue: Crossing Status: Found UCIP Comments: 09/15/2023 Record updated from Non-Urgent to No Action Needed. Pipe was CIPP lined. DMP internal video inspection has found none or minor pipe defects. Recommend next video inspection in 5 years. (O. Yakimov - DWR UCIP) 10/06/2020 Record remains Non-Urgent. DWR DMP has found integrity issues, LOF between 4 and 5. Crossing will be monitored until funding becomes available for rehabilitation. No permit was found authorizing this encroachment. CVFPB will need to review crossing to determine owner. Dense vegetation was found along the WS and LS toe. Recommend removing vegetation along the pipe alignment. Based on the 2014 photos, the LS toe appears to be heavily silted up. Recommend removing silt to increase flow capacity and meet pipe design capacity. (B. Singh - GEI, O. Magana - DWR UCIP)04/08/2014 Heavy sediment buildup in pipe at LS toe. (DWR UCIP - W. Wylie) FIELD_STRUCT_DESC: 24-inch CIPP-lined corrugated metal (CM) gravity drainage pipe through the levee, 13.6 feet below the crown. Flap gate on the waterside (WS) end. Brass cap No. 108 bench mark (BM) on the headwall on the landside (LS). [Additional Reference(s): DWR Levee Log, 2002, (HLM 1.70). USACE San Joaquin O&M Manual, Unit No. 601, Part No. 1, (SJR601.1), 1967, Revised 25 May 2011, (HLM 1.69)]. FS Date: 10/6/2020

Overview of levee crown, looking US

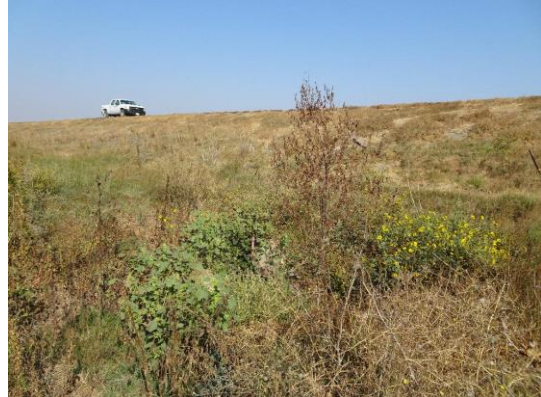
Photo 2 of 3 : UCIP_SP_2024_70644_90575.jpg

WS view: Flapgate and headwall visible at WS toe; dense vegetation

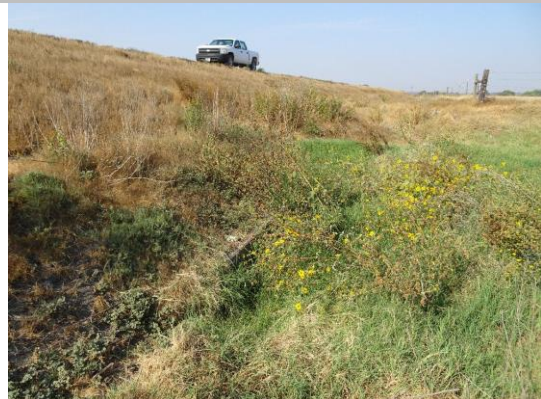
Photo 3 of 3 : UCIP_SP_2024_70644_90576.jpg

LS view: Headwall and pipe partially visible at LS toe; dense vegetation

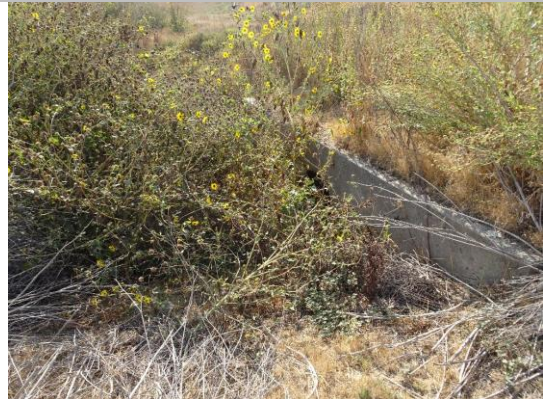
Photo 3 of 3 : UCIP_SP_2024_77847_90578.jpg

LM Start	1.81	Rating **	U	Issue No.	1194 (cont)
LM End	1.81	Issue Type +	Ma	Location *	
Category	Supplemental			GPS Latitude/Longitude	
				Start	End
Item	DWR UCIP LMA Responsibility			37.335612°	37.335612°
				-120.942532°	-120.942532°
DWR ID	19590

LS view: Pipe and concrete headwall partially visible at LS toe

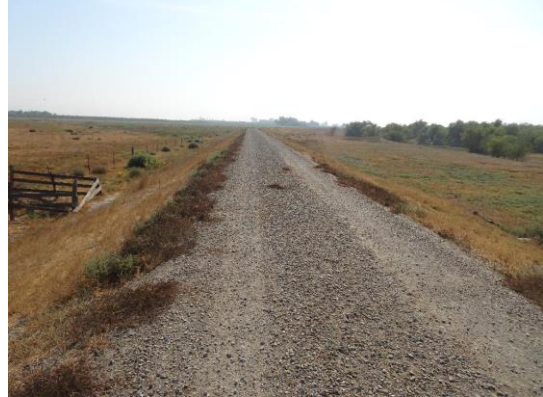
Photo 2 of 3 : UCIP_SP_2024_83239_90611.jpg

Overview of levee crown, looking US

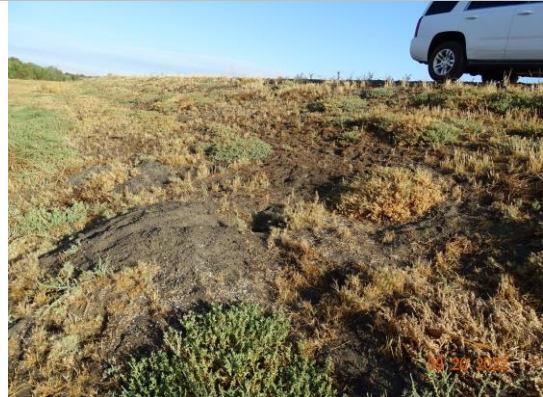
Photo 1 of 1 : SP_2024_NA0010_118_122_20240212_00021.jpg

LM Start	1.97	Rating **	M	Issue No.	122
LM End	1.97	Issue Type +	Ma	Location *	WS
Category	Earthen Levee			GPS Latitude/Longitude	
				Start	End
Item	Animal Control			37.334259°	37.334259°
				-120.940113°	-120.940113°
DWR ID	DWR_NA0010_01_f_2022_122				
Comment Code					
A3 : No rodents visible, but rodent burrows visible; need to backfill and compact or grout burrows.					
Inspector Comment

View of large rodent burrow on the waterside slope. (Fall 2022)

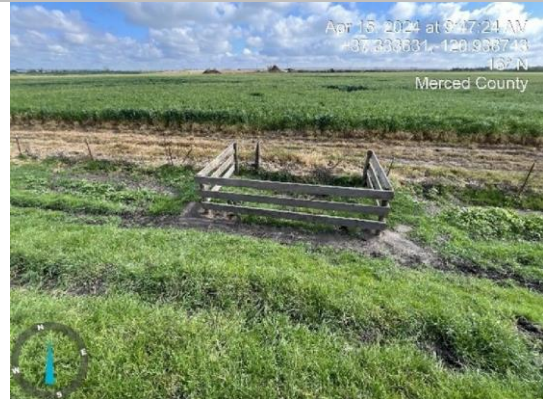
Photo 1 of 3 : UCIP_SP_2024_83241_121610.jpg

Comment Code						
Inspector Comment						
DS_ID:19570 FS_ID:83241 EP_NO: N/A Repair Type: No Action Needed EVAL Issue: Crossing Status: Found UCIP Comments: 04/23/2024 Record updated from Non-Urgent to No Action Needed. DMP internal video inspection has found none or minor pipe defects. Wooden barrier noted in the 10/06/2020 inspection surrounding drop-inlet has been corrected. (M. Thao - DWR UCIP) 12/19/2022 Record updated from Urgent to Non-Urgent. Pipe has been CIPP-lined. LOF of crossing is less or equal to 4. Recommend next video inspection in 5 years. (O. Yakimov - DWR UCIP). 10/06/2020 Record updated from Non-Urgent to Urgent. DMP internal video inspection has found pipe integrity issues. LOF of crossing is between 5 and 6. Crossing will be monitored until funding becomes available to address the issues. Wooden barrier surrounding drop-inlet is dilapidated. No permit was found authorizing this encroachment. CVFPB will need to review crossing to determine owner. (B. Singh - GEI, O. Magana - DWR UCIP) 04/08/2014 Unable to find inlet on landward toe. Recommend clearing vegetation on landward side to properly inspect inlet. (W. Wylie - DWR UCIP) FIELD_STRUCT_DESC: 24-inch CIPP-lined corrugated metal (CM) gravity drainage pipe through the levee, 9.8 feet below the crown. Flap gate on the waterside (WS) end. Brass cap No. 100 bench mark (BM) on the headwall on the landside (LS). [Additional Reference(s): DWR Levee Log, 2002, (HLM 2.08). USACE San Joaquin O&M Manual, Unit No. 601, Part No. 1, (SJR601.1), 1967, Revised 25 May 2011, (HLM 2.08)]. FS Date: 10/6/2020 4:15:32 PM

LS view: Corrected wood barrier around drop-inlet on LS toe (photo sent by LMA).

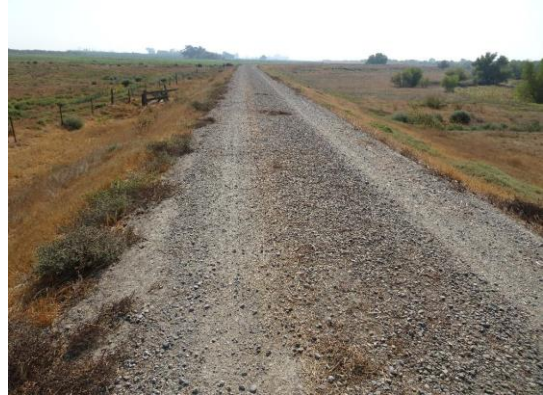
Photo 2 of 3 : UCIP_SP_2024_83241_90617.jpg

Overview of levee crown, looking US

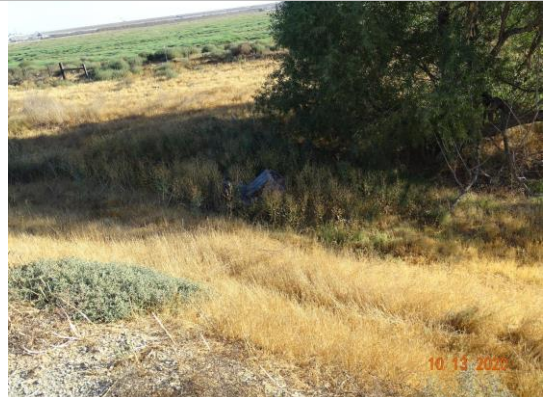
Photo 1 of 1 : SP_2024_NA0010_118_110_20240212_00012.jpg

LM Start	2.20	Rating **	N	Issue No.	110
LM End	2.20	Issue Type +	Ma	Location *	LS
Category	Earthen Levee			GPS Latitude/Longitude	
				Start	End
Item	Trim / Thin Trees			37.331820°	37.331820°
				-120.937605°	-120.937605°
DWR ID	DWR_NA0010_01_f_2018_110				
Comment Code					
T5 : Tree stumps.					
Inspector Comment					
Tree stump on landside slope should be removed.

View of tree stump on the landside slope. (Fall 2020)

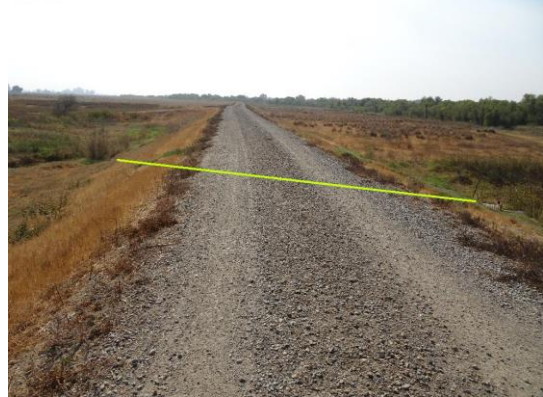
Photo 1 of 3 : UCIP_SP_2024_77843_90625.jpg

Comment Code					
Inspector Comment					
DS_ID:19571 FS_ID:77843 EP_NO: N/A Repair Type: Urgent EVAL Issue: 1, Pipe Integrity Crossing Status: Found UCIP Comments: 12/14/2022 Record updated from Non-Urgent to Urgent. DMP internal video inspection has found pipe integrity issues. LOF of crossing is between 5 and 6. Crossing will be monitored until funding becomes available to address the issues. (O.Yakimov - DWR UCIP) 10/06/2020 Record has been updated from No Action Needed to Non-Urget. Pipe angle through the levee. System description has been updated. No permit was found authorizing this encroachment. CVFPB will need to review crossing to determine owner. DWR DMP internal inspection is pending and scheduled for 2021. (B. Singh - GEI, O. Magana - DWR UCIP) FIELD_STRUCT_DESC: 36-inch corrugated metal (CM) gravity drainage pipe through the levee at an angle, 12.6 feet below the crown. Flap gate on the waterside (WS) end. Brass cap No. 100 bench mark (BM) on the headwall on the landside (LS). Wooden barrier around drop inlet on the LS toe. [Additional Reference(s): DWR Levee Log, 2002, (HLM 2.25). USACE San Joaquin O&M Manual, Unit No. 601, Part No. 1, (SJR601.1), 1967, Revised 25 May 2011, (HLM 2.25)]. FS Date: 10/6/2020 11:56:25 AM

Overview of levee crown, looking US. Pipe angled through levee at alignment shown

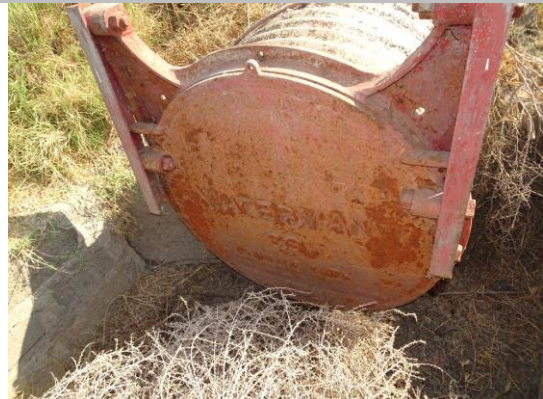
Photo 2 of 3 : UCIP_SP_2024_77843_90628.jpg

WS view: Pipe, flapgate, and headwall on WS toe

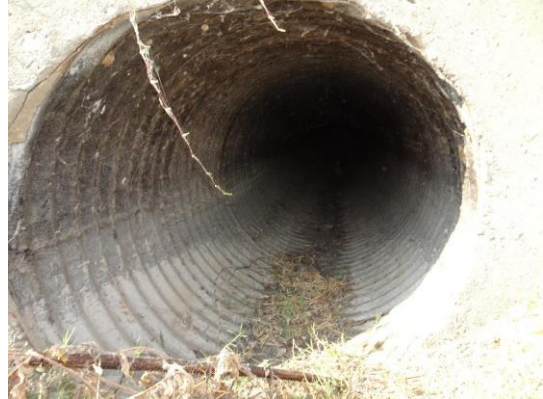
Photo 3 of 3 : UCIP_SP_2024_77843_90623.jpg

LS view: inside view of pipe

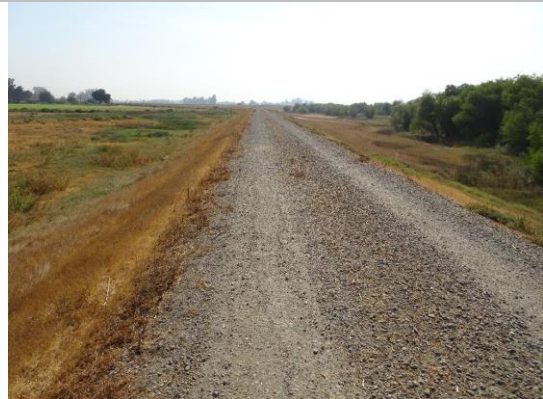
Photo 1 of 3 : UCIP_SP_2024_70649_90632.jpg

DS_ID:19572
FS_ID:70649
EP_NO: N/A
Repair Type: Non-Urgent
EVAL Issue:
Crossing Status: Found
UCIP Comments: 10/06/2020 Record has been updated from No Action Needed to Non-Urgent. No permit was found authorizing this encroachment. CVFPB will need to review crossing to determine owner. DWR DMP has not found internal issues, LOF between 1 and 2. Recommend inspection in 5 years. (B. Singh - GEI, O. Magana - DWR UCIP)
FIELD_STRUCT_DESC: 24-inch corrugated metal (CM) gravity drainage pipe through the levee, 8.0 feet below the crown. Flap gate on the waterside (WS) end. Brass cap No. 100 bench mark (BM) on the headwall on the landside (LS). [Additional Reference(s): DWR Levee Log, 2002, (HLM 2.53). USACE San Joaquin O&M Manual, Unit No. 601, Part No. 1, (SJR601.1), 1967, Revised 25 May 2011, (HLM 2.52)].
FS Date: 10/6/2020

Overview of levee crown, looking US

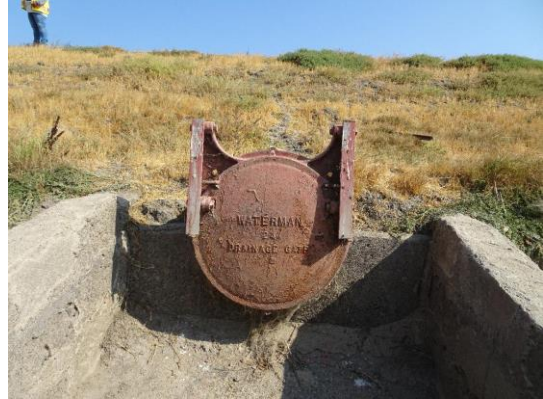
Photo 2 of 3 : UCIP_SP_2024_70649_90635.jpg

WS view: Pipe, flapgate, and headwall on WS toe

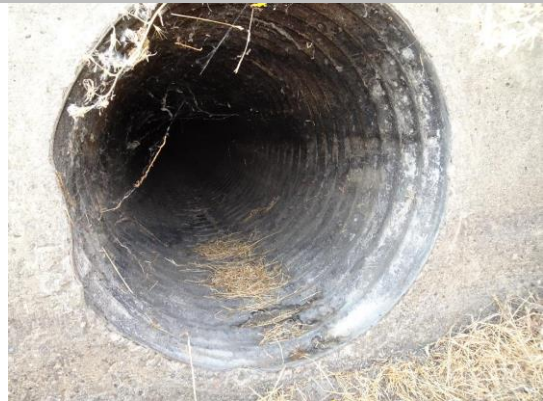
Photo 3 of 3 : UCIP_SP_2024_70649_90636.jpg

LS view: close up view inside pipe inlet

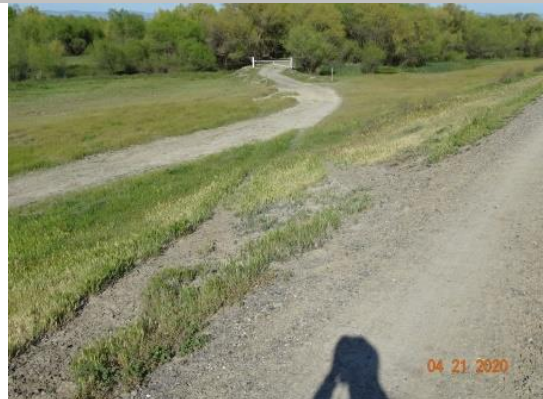
Photo 1 of 1 : SP_2024_NA0010_118_113_20240212_00014.jpg

LM Start	2.58	Rating **	A/W	Issue No.	113
LM End	2.58	Issue Type +	Ma	Location *	WS
Category	Earthen Levee			GPS Latitude/Longitude	
				Start	End
Item	Erosion / Vehicle Traffic			37.327936°	37.327936°
				-120.933013°	-120.933013°
DWR ID	DWR_NA0010_01_f_2018_113				
Comment Code					
E6 : Repair the levee slope damaged by vehicle traffic and prevent access where possible.					
Inspector Comment					
There is damage caused by vehicle traffic over the levee but the integrity of the levee is not compromised. Continue to monitor.

Slope damage by vehicle traffic. (Spring 2020)

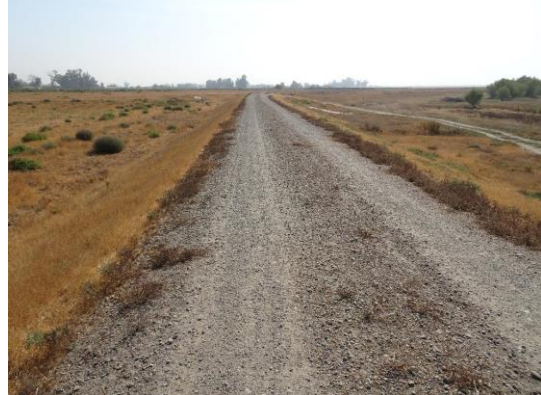
Photo 1 of 3 : UCIP_SP_2024_70650_90637.jpg

Comment Code						
Inspector Comment						
DS_ID:19573 FS_ID:70650 EP_NO: N/A Repair Type: Non-Urgent EVAL Issue: Crossing Status: Found UCIP Comments: 10/06/2020 Record remains Non-Urgent. No permit was found authorizing this encroachment. CVFPB will need to review crossing to determine owner. DWR DMP has not found internal issues, LOF between 1 and 2. Recommend inspection in 5 years. (B. Singh - GEI, O. Magana - DWR UCIP)04/08/2014 Sedimentation in pipe at landward toe. (W. Wylie - DWR UCIP) FIELD_STRUCT_DESC: 24-inch corrugated metal (CM) gravity drainage pipe through the levee, 7.3 feet below the crown. Flap gate on the waterside (WS) end. Brass cap No. 100 bench mark (BM) on the headwall on the landside (LS). [Additional Reference(s): DWR Levee Log, 2002, (HLM 2.71). USACE San Joaquin O&M Manual, Unit No. 601, Part No. 1, (SJR601.1), 1967, Revised 25 May 2011, (HLM 2.70)]. FS Date: 10/6/2020

Overview of levee crown, looking US

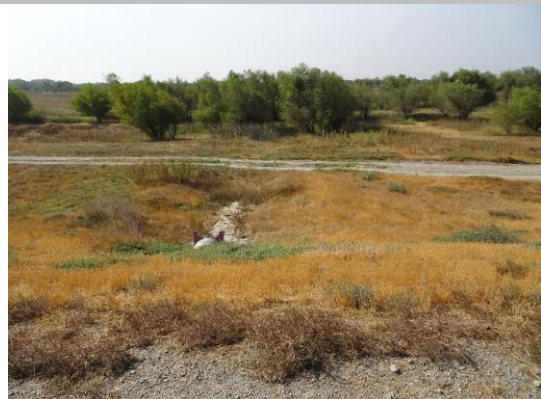
Photo 2 of 3 : UCIP_SP_2024_70650_90638.jpg

WS view: Pipe and flapgate visible on WS toe

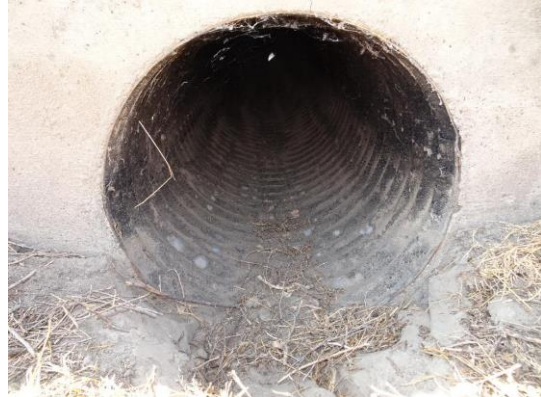
Photo 3 of 3 : UCIP_SP_2024_70650_90642.jpg

WS view: Pipe and headwall at WS toe

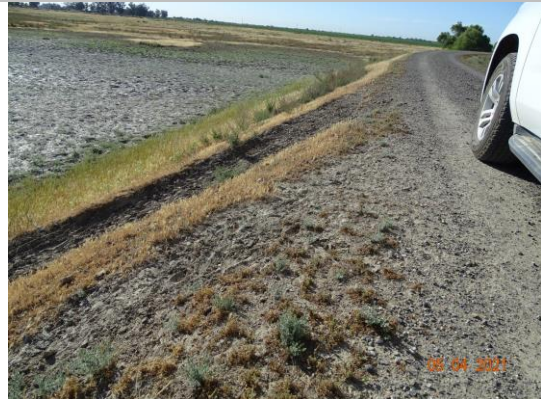
Photo 1 of 1 : SP_2024_NA0010_118_104_20240212_00008.jpg

LM Start	3.06	Rating **	M	Issue No.	104
LM End	3.06	Issue Type +	Ma	Location *	LS
Category	Earthen Levee			GPS Latitude/Longitude	
				Start	End
Item	Erosion / Livestock			37.322499°	37.322499°
				-120.928986°	-120.928986°
DWR ID	DWR_NA0010_01_f_2017_104				
Comment Code					
E4 : Repair the levee slope damaged by livestock and prevent large animal access.					
Inspector Comment					
Slope damage caused by animal foot traffic.

Slope damage on the landside slope from livestock traffic. (Spring 2021)

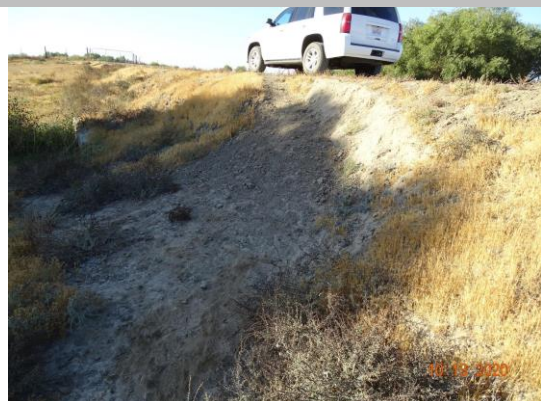
Photo 1 of 1 : SP_2024_NA0010_118_108_20240212_00011.jpg

LM Start	3.13	Rating **	M	Issue No.	108
LM End	3.13	Issue Type +	Ma	Location *	LS
Category	Earthen Levee			GPS Latitude/Longitude	
				Start	End
Item	Erosion / Livestock			37.321488°	37.321488°
				-120.928758°	-120.928758°
DWR ID	DWR_NA0010_01_s_2017_108				
Comment Code					
E4 : Repair the levee slope damaged by livestock and prevent large animal access.					
Inspector Comment					
Slope damage caused by animal traffic on landside toe.

View of landside slope damage by animal traffic. (Fall 2020)

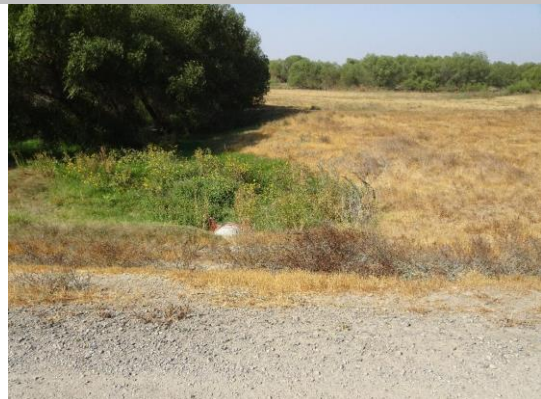
Photo 2 of 3 : UCIP_SP_2024_77846_90645.jpg

WS view: Pipe and flapgate visible at WS toe

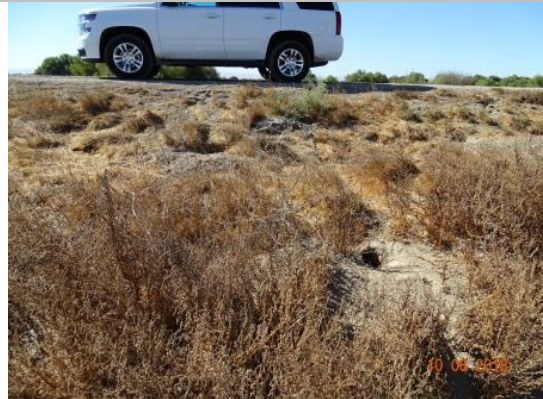
Photo 1 of 1 : SP_2024_NA0010_118_116_20240212_00017.jpg

LM Start	3.18	Rating **	A/W	Issue No.	116
LM End	3.18	Issue Type +	Ma	Location *	LS
Category	Earthen Levee			GPS Latitude/Longitude	
				Start	End
Item	Animal Control			37.320725 °	37.320725 °
				-120.928837 °	-120.928837 °
DWR ID	DWR_NA0010_01_f_2018_116				
Comment Code					
A3 : No rodents visible, but rodent burrows visible; need to backfill and compact or grout burrows.					
Inspector Comment

View of landside slope with rodent holes. (Fall 2018)

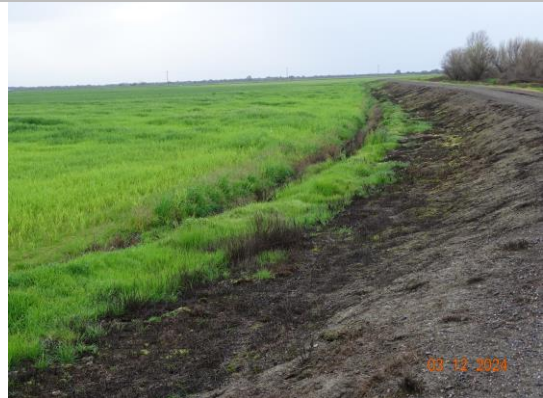
Photo 1 of 1 : SP_2024_NA0010_118_117_20240326_00257.jpg

LM Start	3.23	Rating **	M	Issue No.	117
LM End	3.90	Issue Type +	En	Location *	LS
Category	Earthen Levee			GPS Latitude/Longitude	
				Start	End
Item	Encroachments			37.320029°	37.311311°
				-120.928556°	-120.927310°
DWR ID	DWR_NA0010_01_f_2018_117				
Comment Code					
DT : Ditch					
Inspector Comment					
Earthen ditch along landside toe.

Small ditch along the landside toe. (Spring 2024)

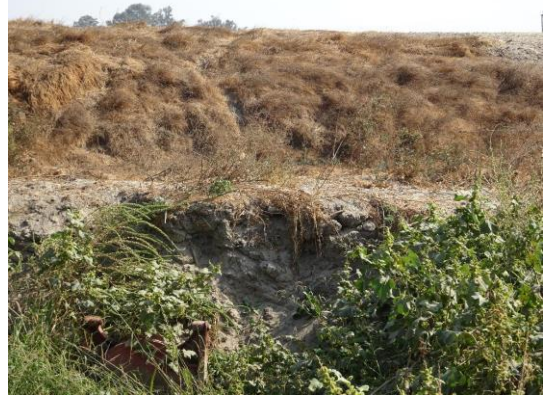
Photo 2 of 3 : UCIP_SP_2024_70652_90586.jpg

WS view: Slope from WS toe

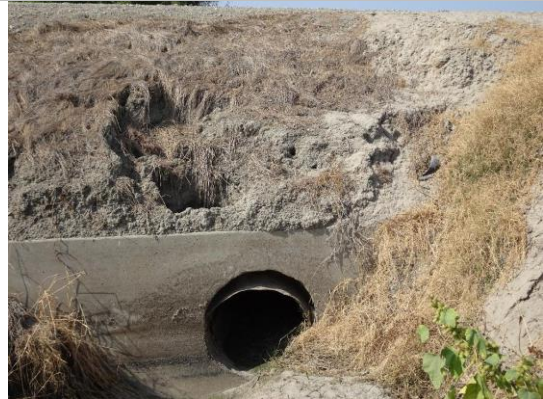
Photo 3 of 3 : UCIP_SP_2024_70652_90591.jpg

Comment Code						
Inspector Comment						
DS_ID:19575 FS_ID:70652 EP_NO: N/A Repair Type: Urgent EVAL Issue: 1, Pipe Integrity Crossing Status: Found UCIP Comments: 10/06/2020 Record remains Urgent. Sinkhole present directly above the LS headwall and along pipe alignment. Pipe collapse visible from from the LS toe. Erosion present on the WS just behind the flap gate. No permit was found authorizing this encroachment. CVFPB will need to review crossing to determine owner. DWR DMP internal inspection is pending and scheduled in 2021. (B. Singh - GEI, O. Magana - DWR UCIP)11/01/2018 Pipe continues to rust through, causing the pipe to collapse on the LS. Sediment buildup visible from the LS inlet. Loss of soil just above the LS concrete headwall and along the LS slope. Crossing remains Urgent due to the levee slope issues and pipe failure through the levee. (O. Magana - DWR UCIP)07/19/2016 Same as previous inspection. Erosion present on LS slope. (O. Magana - DWR UCIP)04/08/2014 Pipe rusted through at Springline on LS toe. Flapgate blocked by sediment on WS toe. Heavy sediment on both ends of pipe. Need to contact owner to address issues. (W. Wylie - DWR UCIP) FIELD_STRUCT_DESC: 36-inch corrugated metal (CM) gravity drainage pipe through the levee, 9.7 feet below the crown. Flap gate on the waterside (WS) end. Brass cap No. 100 bench mark (BM) on the headwall on the landside (LS). [Additional Reference(s): DWR Levee Log, 2002, (HLM 3.50). USACE San Joaquin O&M Manual, Unit No. 601, Part No. 1, (SJR601.1), 1967, Revised 25 May 2011, (HLM 3.50)]. FS Date: 10/6/2020

LS view: Pipe, headwall, and sinkhole at LS toe

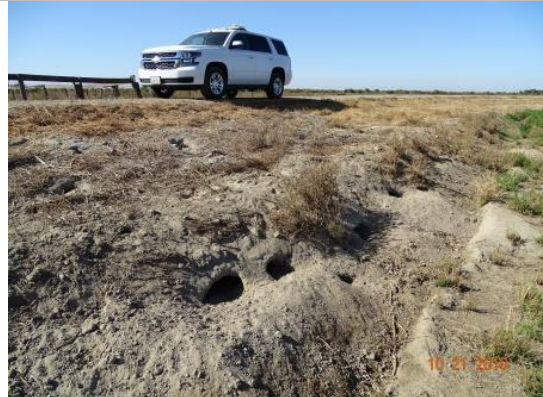
Photo 1 of 1 : SP_2024_NA0010_118_2_20240212_00001.jpg

LM Start	3.87	Rating **	A/W	Issue No.	2
LM End	3.90	Issue Type +	Ma	Location *	LS
Category	Earthen Levee			GPS Latitude/Longitude	
				Start	End
Item	Animal Control			37.311798°	37.311341°
				-120.927670°	-120.927365°
DWR ID	DWR_NA0010_01_s_2012_2				
Comment Code					
A1 : Exterminate rodents and backfill and compact or grout burrows.					
Inspector Comment

View of rodent burrows in this section looking downstream. (Fall 2019)

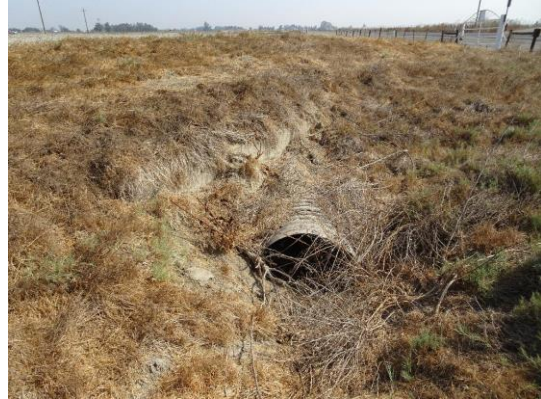
Photo 2 of 3 : UCIP_SP_2024_70653_90652.jpg

WS view: Heavy siltation at WS invert. Pipe flapgate missing at WS toe.

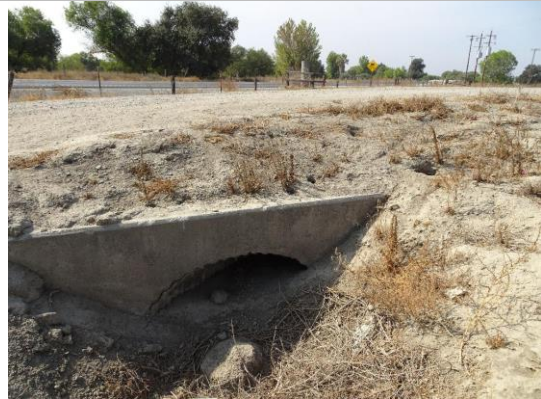
Photo 3 of 3 : UCIP_SP_2024_70653_90655.jpg

LS view: Pipe and headwall at LS toe. Heavy siltation at invert.

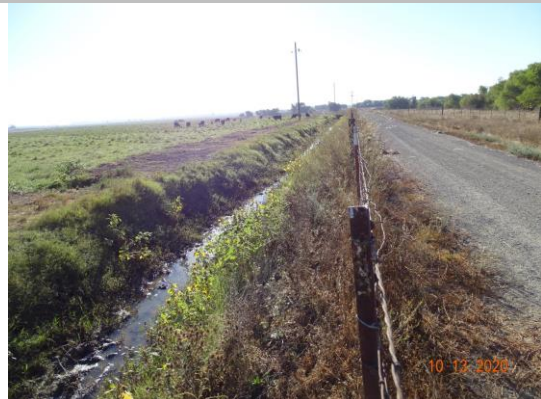
Photo 1 of 1 : SP_2024_NA0010_118_5_20240212_00002.jpg

LM Start	3.98	Rating **	U	Issue No.	5
LM End	4.05	Issue Type +	En	Location *	LS
Category	Earthen Levee			GPS Latitude/Longitude	
				Start	End
Item	Encroachments			37.310837°	37.310003°
				-120.926182°	-120.925313°
DWR ID	DWR_NA0010_01_s_2012_5				
Comment Code					
DT : Ditch					
Inspector Comment					
Irrigation ditch at landside toe.

Looking south at irrigation ditch at the landside toe. (Fall 2020)

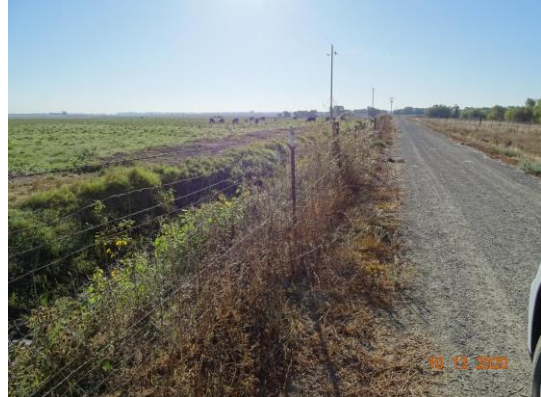
Photo 1 of 1 : SP_2024_NA0010_118_118_20240212_00019.jpg

LM Start	3.99	Rating **	M	Issue No.	118
LM End	4.25	Issue Type +	En	Location *	LS
Category	Earthen Levee			GPS Latitude/Longitude	
				Start	End
Item	Encroachments			37.310693 °	37.307895 °
				-120.926024 °	-120.922935 °
DWR ID	DWR_NA0010_01_f_2018_118				
Comment Code					
FE : Fence					
Inspector Comment					
Fence along landside toe.

View of fence on the landside shoulder and toe. (Fall 2020)

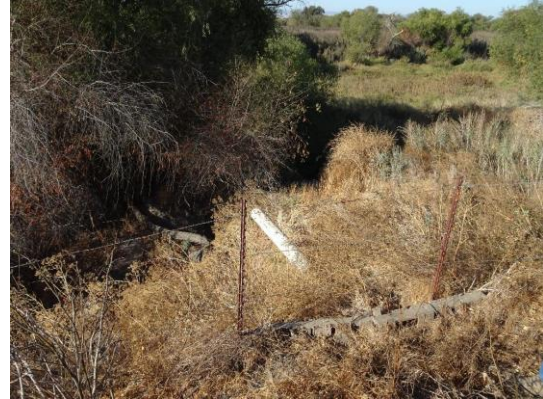
Photo 2 of 3 : UCIP_SP_2024_70655_90662.jpg

WS view: Unauthorized 12-inch PVC pipe on WS, approximately 1 foot below levee crown.

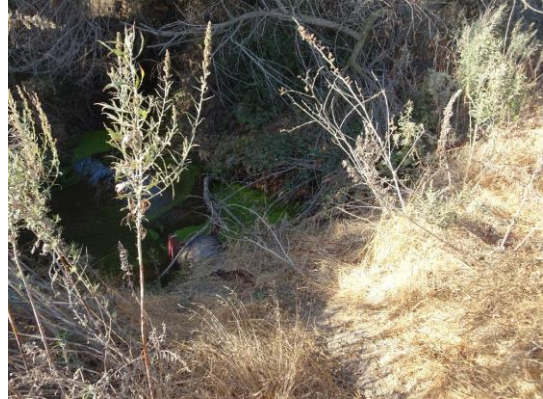
Photo 2 of 3 : UCIP_SP_2024_77849_90672.jpg

WS view: Pipe and flapgate visible at WS toe. Further inspection inhibited by barbed wire fencing

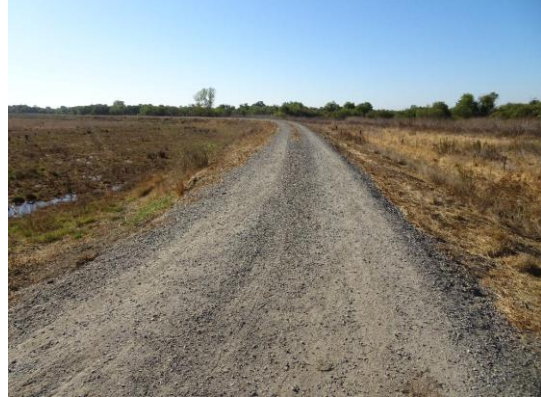
Photo 1 of 3 : UCIP_SP_2024_70658_90676.jpg

Comment Code					
Inspector Comment					
DS_ID:19609 FS_ID:70658 EP_NO: N/A Repair Type: Urgent EVAL Issue: 1, Pipe Integrity Crossing Status: Found UCIP Comments: 10/20/2020 Record has been updated from Non-Urgent to Urgent. DWR DMP has found integrity issues, LOF, between 5 and 6. Crossing will be monitored until funding becomes available to address. Evidence of the landslide visible on the LS slope from the levee crown. No permit was found authorizing this encroachment. CVFPB will need to review crossing to determine owner. (B. Singh - GEI, O. Magana - DWR UCIP)04/08/2014 Dense vegetation limits the inspector's visibility to identify signs of pipe failure (leaks) along the waterward side. Recommend removing vegetation along pipe alignment to conduct proper inspection of structure and appurtenances. (W. Wylie - DWR UCIP) FIELD_STRUCT_DESC: 24-inch corrugated metal (CM) gravity drainage pipe through the levee, 10.0 feet below the crown. Flap gate on the waterside (WS) end. Brass cap No. 90 bench mark (BM) on the headwall on the landside (LS). [Additional Reference(s): DWR Levee Log, 2002, (HLM 4.73). USACE San Joaquin O&M Manual, Unit No. 601, Part No. 1, (SJR601.1), 1967, Revised 25 May 2011, (HLM 4.72)]. FS Date: 10/20/2020

Overview of levee crown, looking US

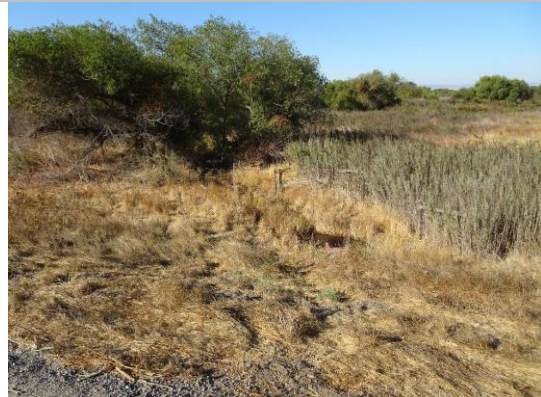
Photo 2 of 3 : UCIP_SP_2024_70658_90678.jpg

WS view: Pipe and flapgate visible at WS toe

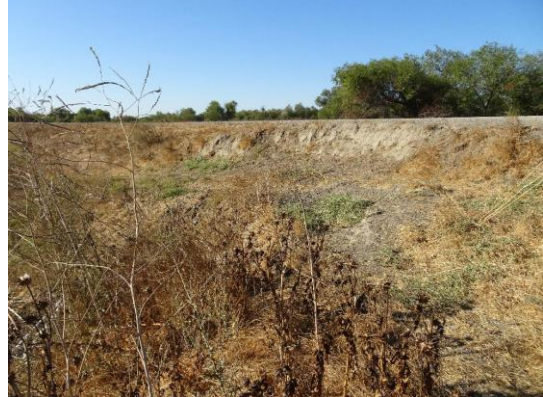
Photo 3 of 3 : UCIP_SP_2024_70658_90681.jpg

LS view: land movement/scarp of LS slope at levee crown

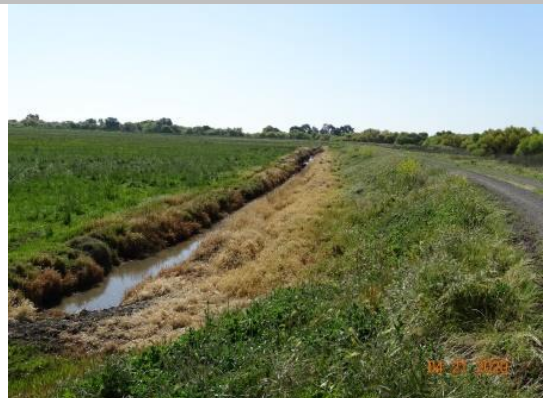
Photo 1 of 1 : SP_2024_NA0010_118_107_20240212_00010.jpg

LM Start	4.77	Rating **	M	Issue No.	107
LM End	5.32	Issue Type +	En	Location *	LS
Category	Earthen Levee			GPS Latitude/Longitude	
				Start	End
Item	Encroachments			37.301269°	37.300396°
				-120.920660°	-120.912625°
DWR ID	DWR_NA0010_01_s_2019_107				
Comment Code					
DT : Ditch					
Inspector Comment					
Ditch it roughly 8-15 ft away from levee toe.

Looking upstream at an irrigation ditch along the landside toe. (Spring 2020)

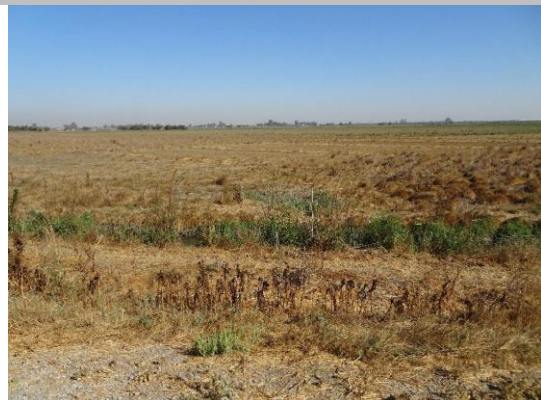
Photo 2 of 3 : UCIP_SP_2024_70659_90683.jpg

LS view: Pipe and headwall not visible at LS toe from levee crown

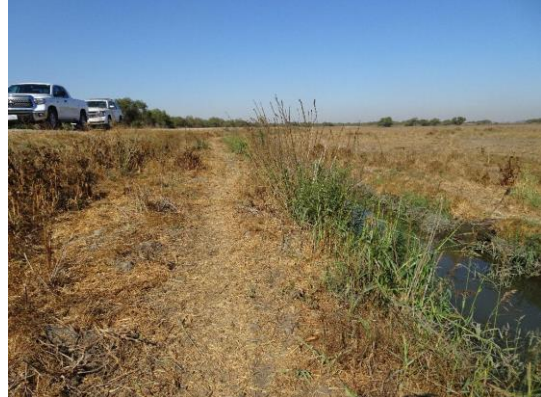
Photo 3 of 3 : UCIP_SP_2024_70659_90685.jpg

LS view: LS pipe and headwall not accessible/visible due to high vegetation

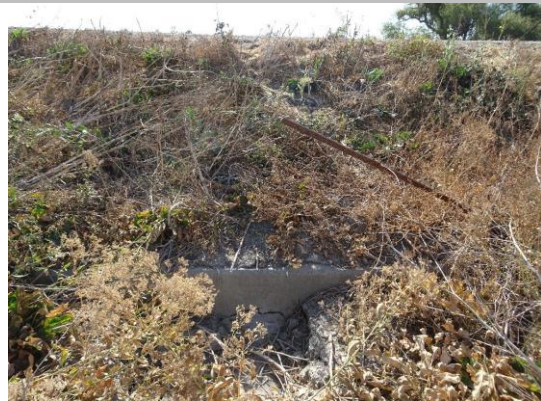
Photo 3 of 3 : UCIP_SP_2024_77850_90692.jpg

LS view: Headwall at LS toe. Pipe is completely blocked by heavy siltation at LS invert.

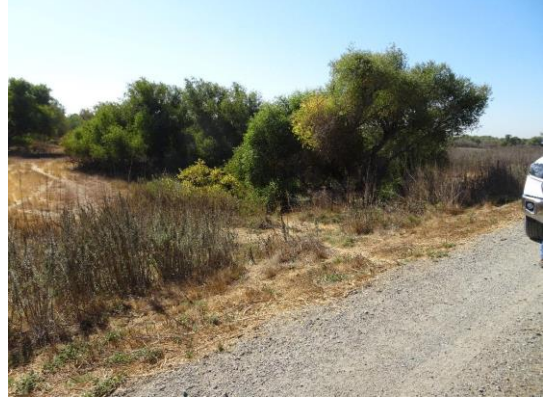
Photo 2 of 3 : UCIP_SP_2024_77851_90698.jpg

DS_ID:19612
FS_ID:77851
EP_NO: N/A
Repair Type: Urgent
EVAL Issue: 1, Pipe Integrity
Crossing Status: Found
UCIP Comments: 12/14/2022 Record updated from Non-Urgent to Urgent. DMP internal video inspection has found pipe integrity issues. LOF of crossing is between 5 and 6. Crossing will be monitored until funding becomes available to address the issues. (O.Yakimov - DWR UCIP)
10/20/2020 Record remains Non-Urgent. Scour is still present on both sides of the concrete LS headwall. Dense vegetation prevented updates on the scour progression along the LS slope. Recommend re-inspecting pipe when vegetation is removed. Unable to access to WS outlet due to wired fence. No permit was found authorizing this encroachment. CVFPB will need to review crossing to determine owner. DWR DMP internal inspection is pending and scheduled for 2021. (B. Singh - GEI, O. Magana - DWR UCIP)04/08/2014 Dense vegetation limits the inspector's visibility to identify signs of pipe failure (leaks) along waterward and landward slopes. Recommend removing vegetation along pipe alignment to conduct proper inspection of structure and appurtenances. Pipe completely blocked by soil on LS toe due to animal activity. Slide gate blocked open. (W. Wylie - DWR UCIP)

WS view: View of WS toe from levee crown. Headwall, pipe, and flapgate not visible from levee crown.

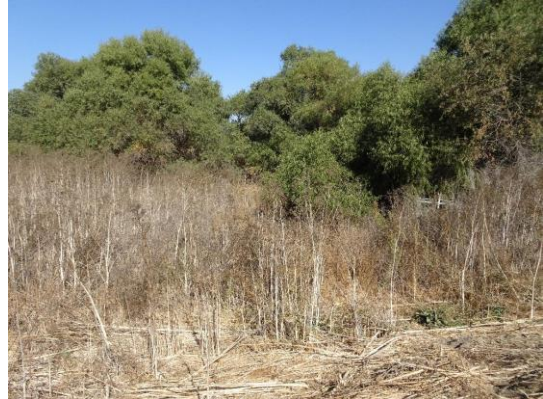
Photo 3 of 3 : UCIP_SP_2024_77851_90697.jpg

LS view: View toward LS toe. Slidegate visible through dense vegetation

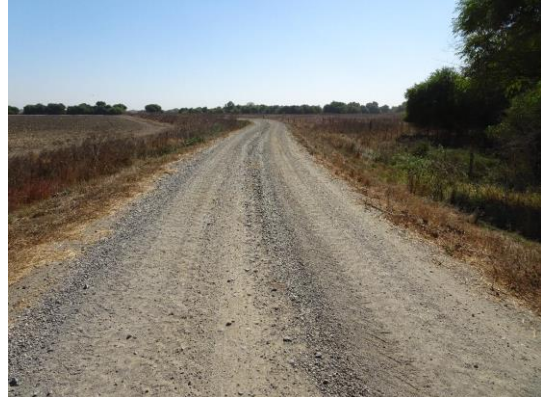
Photo 1 of 3 : UCIP_SP_2024_70663_90712.jpg

Comment Code					
Inspector Comment					
DS_ID:19614 FS_ID:70663 EP_NO: N/A Repair Type: Non-Urgent EVAL Issue: Crossing Status: Found UCIP Comments: 10/20/2020 Record remains Non-Urgent. Dense vegetation inhibits inspection of the pipe on the LS toe, and both slopes. No permit was found authorizing this encroachment. CVFPB will need to review crossing to determine owner. DWR DMP internal inspection is pending and scheduled for 2021. (B. Singh - GEI, O. Magana - DWR UCIP)7/19/2016 Same as previous inspection. Outlet and inlet are under water. (O. Magana - DWR UCIP)4/08/2014 Flapgate blocked by sedimentation at WS toe. Dense vegetation limits the inspector's visibility to identify signs of pipe failure (leaks) along the slope. Recommend removing vegetation along pipe alignment to conduct proper inspection of structure and appurtenances. Also recommend clearing vegetation from both waterward and landward toe. (W. Wylie - DWR UCIP) FIELD_STRUCT_DESC: 24-inch corrugated metal (CM) gravity drainage pipe through the levee, 9.8 feet below the crown. Wooden fence around a 4-foot by 4-foot drop inlet on the landside (LS) toe. Flap gate on the waterside (WS) end. Brass cap No. 90 bench mark (BM) on the headwall on the LS. [Additional Reference(s): DWR Levee Log, 2002, (HLM 6.65). USACE San Joaquin O&M Manual, Unit No. 601, Part No. 1, (SJR601.1), 1967, Revised 25 May 2011, (HLM 6.64)]. FS Date: 10/20/2020

Overview of levee crown, looking US

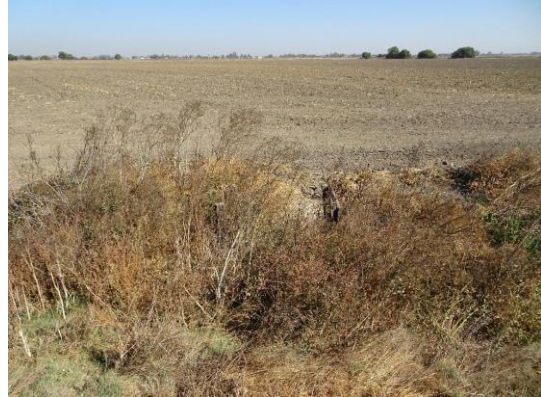
Photo 2 of 3 : UCIP_SP_2024_70663_90713.jpg

LS view: Dense vegetation on LS limiting view of wooden barrier around drop-inlet.

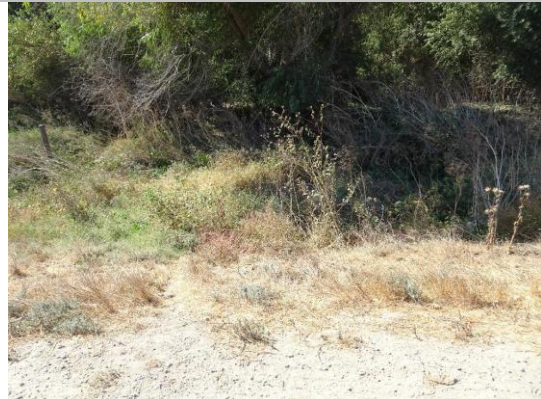
Photo 3 of 3 : UCIP_SP_2024_70663_90708.jpg

WS view: Pipe and flapgate at WS toe not visible from levee crown due to dense vegetation

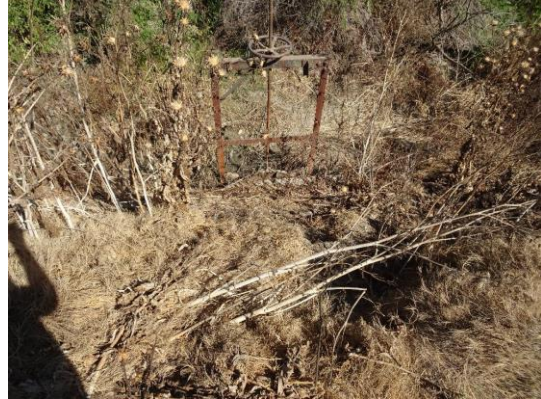
Photo 2 of 3 : UCIP_SP_2024_70664_90728.jpg

LS view: Surface erosion above LS headwall

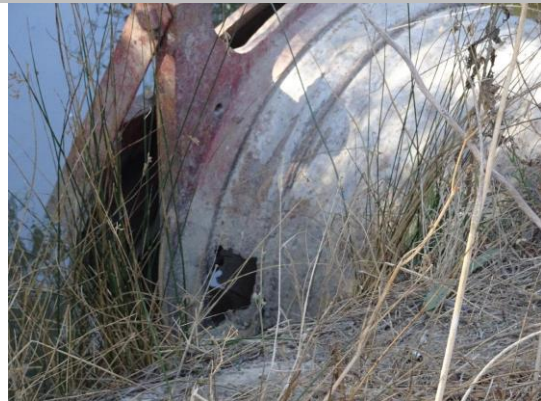
Photo 3 of 3 : UCIP_SP_2024_70664_90723.jpg

WS view: Extensive corrosion visible at WS invert

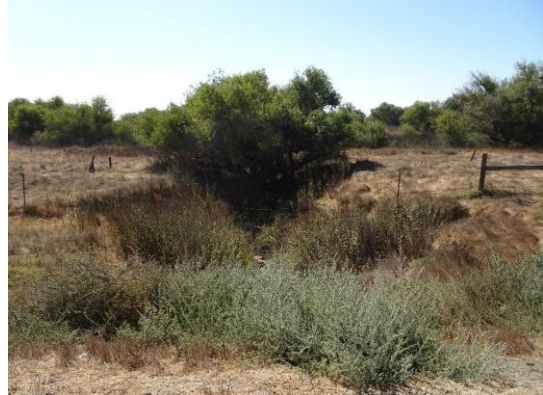
Photo 2 of 3 : UCIP_SP_2024_70665_90717.jpg

WS view: Pipe and flapgate at WS toe not visible from levee crown due to vegetation.

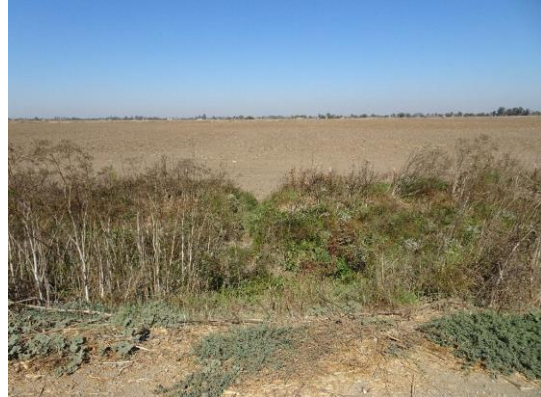
Photo 2 of 3 : UCIP_SP_2024_83244_90739.jpg

LS view: Headwall not visible at LS toe from levee crown due to vegetation

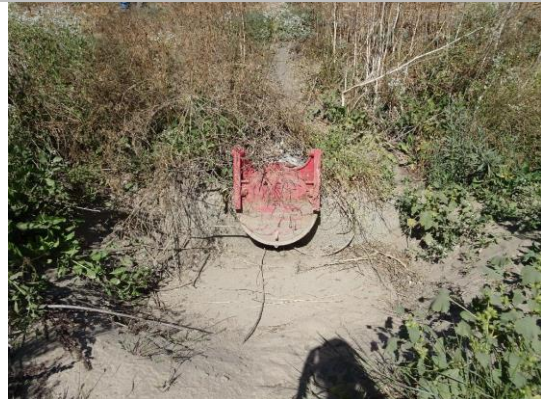
Photo 3 of 3 : UCIP_SP_2024_83244_90736.jpg

WS view: Pipe, flapgate and headwall at WS toe. Flapgate damaged and non-functional

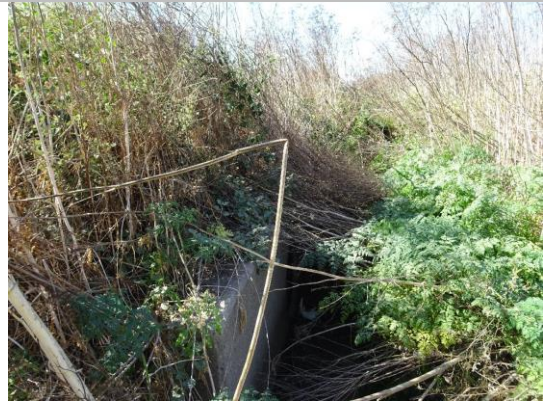
Photo 2 of 3 : UCIP_SP_2024_70668_90747.jpg

LS view: Headwall at LS toe. Dense vegetation blocking view
