Flood Control Project Maintenance
Levee Inspections
LMA District Cover Sheet

Lower San Joaquin Levee District

**Flood Control Project Maintenance
Levee Inspections
Unit Cover Sheet**

Levee Inspection Report By Mile - Spring 2024

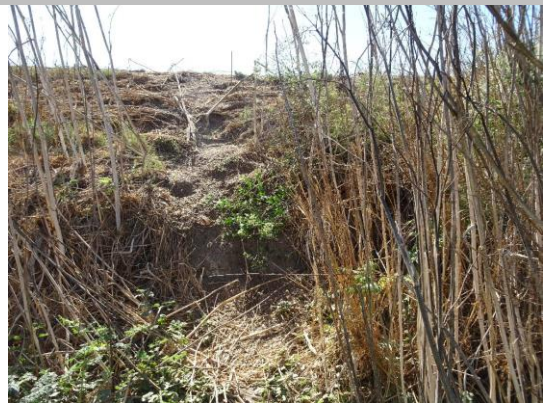
Photo 3 of 3 : UCIP_SP_2024_70668_90749.jpg

LS view: Sloughing above headwall and pipe on LS slope

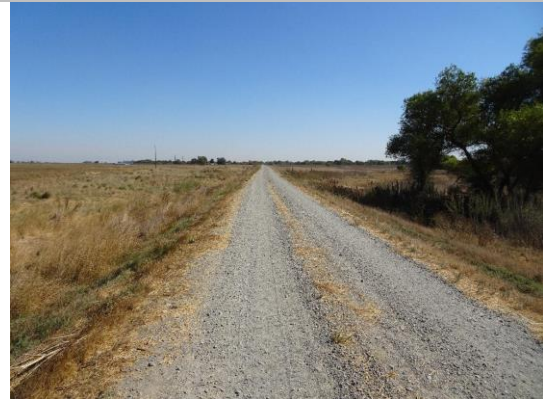
Photo 1 of 3 : UCIP_SP_2024_70669_90750.jpg

DS_ID:19620
FS_ID:70669
EP_NO: N/A
Repair Type: No Action Needed
EVAL Issue:
Crossing Status: Found
UCIP Comments: 09/15/2023 Record updated from Non-Urgent to No Action Needed. Pipe was CIPP lined. DMP internal video inspection has found none or minor pipe defects. Recommend next video inspection in 5 years. (O. Yakimov - DWR UCIP)
10/20/2020 Record remains Non-Urgent. DWR DMP has found integrity issues, LOF between 4 and 5. Corrosion in pipe visible on the LS toe. Crossing will be monitored until funding becomes available for rehabilitation. No permit was found authorizing this encroachment. CVFPB will need to review crossing to determine owner. (B. Singh - GEI, O. Magana - DWR UCIP)04/09/2014 Dense vegetation limits the inspector's visibility to identify signs of pipe failure (leaks) along the slope. Recommend removing vegetation along pipe alignment to conduct proper inspection of structure. (W. Wylie - DWR UCIP)

Overview of levee crown, looking US

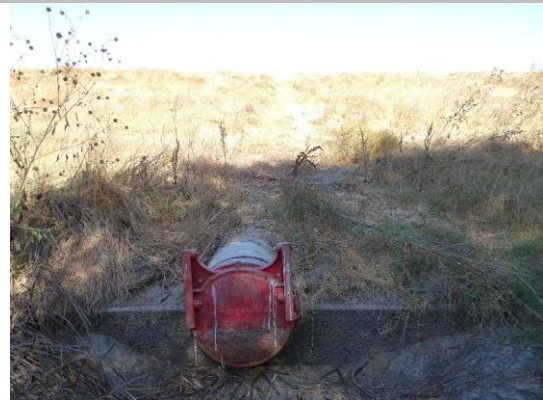
Photo 2 of 3 : UCIP_SP_2024_70669_90755.jpg

Pipe, flapgate, and headwall at WS toe

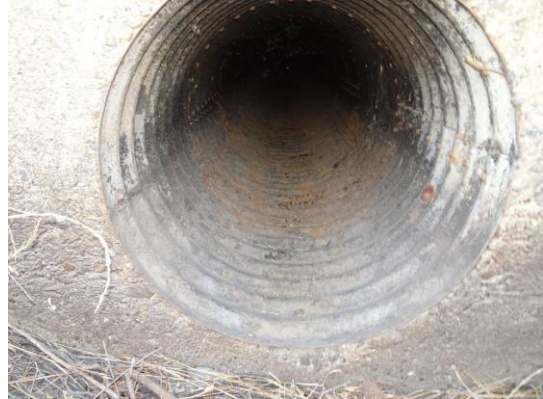
Photo 3 of 3 : UCIP_SP_2024_70669_90753.jpg

Headwall and pipe at LS toe. Visible corrosion in pipe.

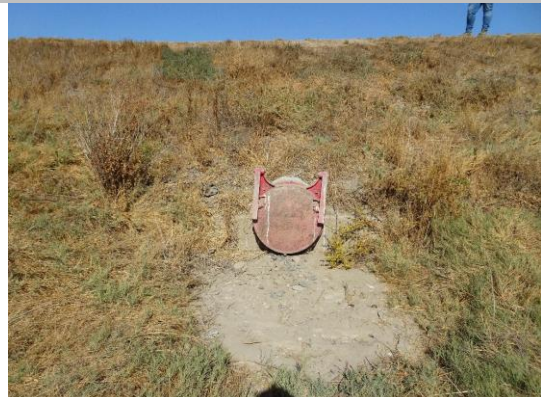
Photo 2 of 3 : UCIP_SP_2024_70670_90756.jpg

WS view: Pipe, flapgate, and headwall at WS toe

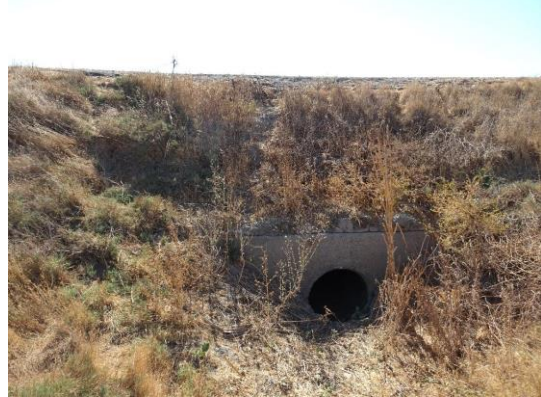
Photo 3 of 3 : UCIP_SP_2024_70670_90762.jpg

LS view: Pipe, headwall, and slope from LS toe

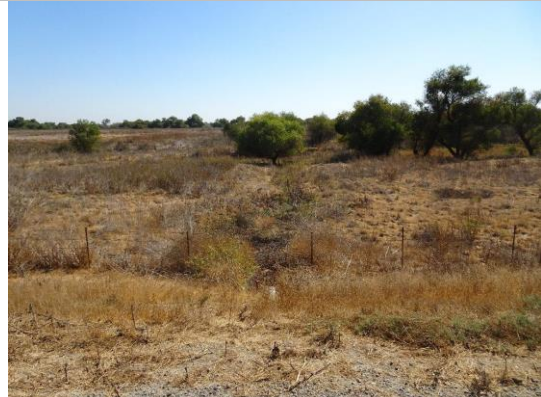
Photo 2 of 3 : UCIP_SP_2024_70672_90772.jpg

Comment Code						
Inspector Comment						
DS_ID:19622 FS_ID:70672 EP_NO: N/A Repair Type: Non-Urgent EVAL Issue: Crossing Status: Found UCIP Comments: 10/20/2020 Record has been updated from No Action Needed to Non-Urgent. Large burrow hole observed approximately 100 feet downstream of the pipe, on LS shoulder of the levee crown. No permit was found authorizing this encroachment. CVFPB will need to review crossing to determine owner. DWR DMP has not found internal issues, LOF between 1 and 2. Recommend inspection in 5 years. (B. Singh - GEI, O. Magana - DWR UCIP) FIELD_STRUCT_DESC: 24-inch corrugated metal (CM) gravity drainage pipe through the levee, 9.0 feet below the crown. Flap gate on the waterside (WS) end. Brass cap No. 80 bench mark (BM) on the headwall on the landside (LS). [Additional Reference(s): DWR Levee Log, 2002, (HLM 8.62). USACE San Joaquin O&M Manual, Unit No. 601, Part No. 1, (SJR601.1), 1967, Revised 25 May 2011, (HLM 8.61)]. FS Date: 10/20/2020

WS view: Pipe and flapgate visible on WS toe

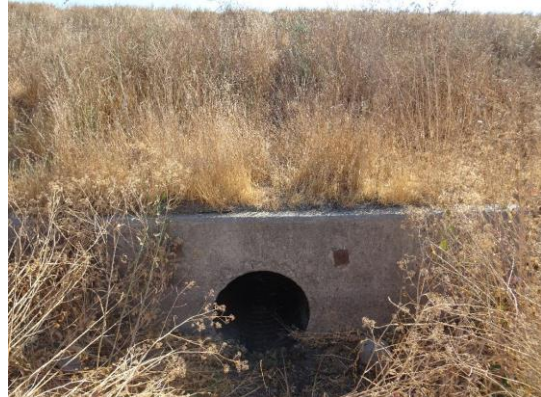
Photo 3 of 3 : UCIP_SP_2024_70672_90773.jpg

LM Start	8.57	Rating **	M	Issue No.	1218 (cont)
LM End	8.57	Issue Type +	Ma	Location *	
Category	Supplemental			GPS Latitude/Longitude	
				Start	End
Item	DWR UCIP LMA Responsibility			37.296552°	37.296552°
				-120.858596°	-120.858596°
DWR ID	19622

LS view: Pipe and headwall on LS toe

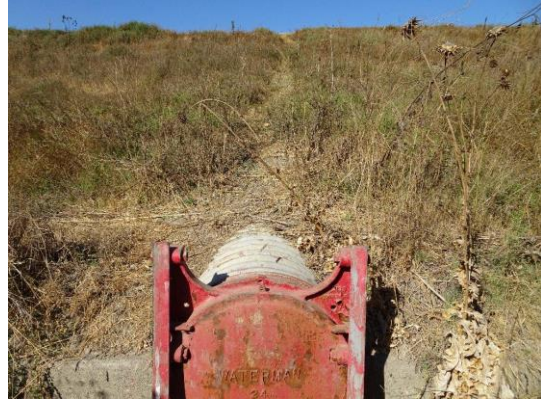
Photo 2 of 3 : UCIP_SP_2024_83245_90777.jpg

DS_ID:19623
FS_ID:83245
EP_NO: N/A
Repair Type: No Action Needed
EVAL Issue:
Crossing Status: Found
UCIP Comments: 04/23/2024 Record updated from Non-Urgent to No Action Needed. DMP internal video inspection has found none or minor pipe defects. (M. Thao - DWR UCIP)
10/20/2020 Record remains Non-Urgent. No permit was found authorizing this encroachment. CVFPB will need to review crossing to determine owner. DWR DMP has not found internal issues, LOF between 1 and 2. Recommend inspection in 5 years. (B. Singh - GEI, O. Magana - DWR UCIP)
04/09/2014 Dense vegetation limits the inspector's visibility to identify signs of pipe failure (leaks) along the slope. Recommend removing vegetation along pipe alignment to conduct proper inspection of structure. (W. Wylie - DWR UCIP)
FIELD_STRUCT_DESC: 24-inch corrugated metal (CM) gravity drainage pipe through the levee, 9.1 feet below the crown. Flap gate on the waterside (WS) end. Brass cap No. 80 bench mark (BM) on the headwall on the landside (LS). [Additional Reference(s): DWR Levee Log, 2002, (HLM 8.95). USACE San Joaquin O&M, Unit No. 601, Part No. 1, (SJR601.1), 1967, Revised 25 May 2011, (HLM 8.93)].

WS view: Pipe, flapgate, headwall, and slope at WS toe

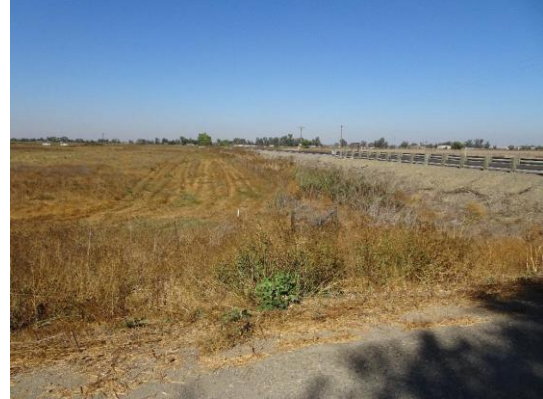
Photo 1 of 3 : UCIP_SP_2024_83428_90783.jpg

Comment Code					
Inspector Comment					
DS_ID:19624 FS_ID:83428 EP_NO: 12156 Repair Type: Urgent EVAL Issue: 3a, Flood Risk Crossing Status: Found UCIP Comments: 10/20/2020 Record remains Urgent. There is no operating gate that will prevent flows from the WS to LS. Dense vegetation prevented a full inspection of this crossing. Need to contact owner to clear the dense vegetation on both the WS and the LS to be able to perform proper inspection of crossing. DWR DMP has completed a geophysical study in this area and plans to complete an internal inspection of this pipe. The pipe is scheduled for an internal inspection in 2021. (B. Singh - GEI, O. Magana - DWR UCIP)11/01/2018 Dense vegetation prevented a full inspection of this crossing. Assumed crossing remains the same as the 2016 inspection. Crossing remains Urgent due to signs of pipe being rusted through visible from the WS. Need to contact owner to clear the dense vegetation on both the WS and the LS to be able to perform proper inspection of crossing. (O. Magana - DWR UCIP)07/19/2016 same as previous inspection--pipe rusted through. Sediment visible inside LS pipe; walkway wood panels have dry rot and appears to be unsafe to use. (O. Magana - DWR UCIP)04/09/2014 Slide gate rusted through and open on WS toe. Inlet appears to be obscured or covered in soil at LS toe. Also dense vegetation on waterward and landward sides. Need to contact owner to contact CVFPB to address issue. (W. Wylie - DWR UCIP) FIELD_STRUCT_DESC: 30-inch reinforced concrete (RC) gravity drainage pipe containing a 26-inch steel pipe through the levee, 7.3 feet below the crown. Annular space grouted. Two concrete cutoff walls in the center of the levee. Slide gate with elevated walkway access on the waterside (WS) end. 6-inch-thick concrete headwall on the WS end. Concrete wing walls on each end. (30-inch drainage pipe with a valve authorized under Permit No. 12156, 1977 - Merquin County Water District. Additional Related Permit(s): Permit No. 12156-A, 1978 - Merquin County Water District). [Additional Reference(s): DWR Levee Log, 2002, (HLM 9.01)]. FS Date: 10/20/2020

LS view: View of LS toe from levee crown

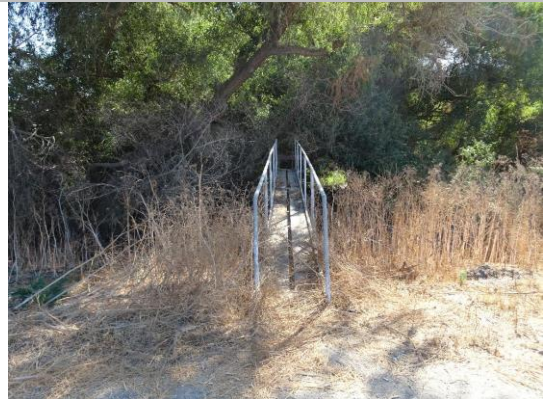
Photo 2 of 3 : UCIP_SP_2024_83428_90784.jpg

LM Start	8.97	Rating **	U	Issue No.	1220 (cont)
LM End	8.97	Issue Type +	En	Location *	
Category	Supplemental			GPS Latitude/Longitude	
				Start	End
Item	DWR UCIP Field Study			37.297423 °	37.297423 °
				-120.851575 °	-120.851575 °
DWR ID	19624

WS view: View toward WS toe

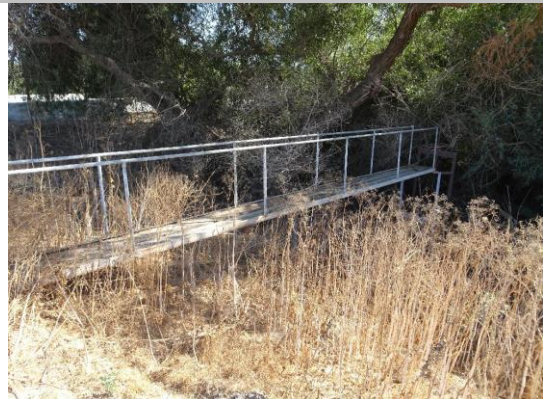
Photo 3 of 3 : UCIP_SP_2024_83428_90786.jpg

WS view: Elevated walkway across WS slope

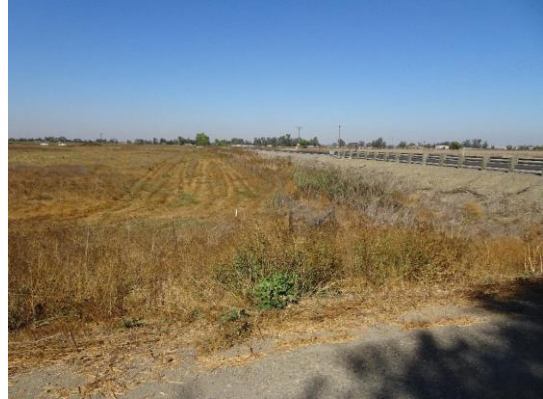
Photo 1 of 3 : UCIP_SP_2024_70675_90789.jpg

Comment Code					
Inspector Comment					
DS_ID:19625 FS_ID:70675 EP_NO: N/A Repair Type: Non-Urgent EVAL Issue: Crossing Status: Found UCIP Comments: 10/20/2020 Record remains Non-Urgent. As in previous inspection, dense vegetation inhibited proper inspection of the pipe and slope. No permit was found authorizing this encroachment. CVFPB will need to review crossing to determine owner. DWR DMP internal inspection is pending and scheduled for 2021. (B. Singh - GEI, O. Magana - DWR UCIP)04/09/2014 Dense vegetation limits the inspector's visibility to identify signs of pipe failure (leaks) along the slope. Recommend removing vegetation along pipe alignment to conduct proper inspection of structure. Some sediment buildup in pipe. (W. Wylie - DWR UCIP) FIELD_STRUCT_DESC: 36-inch corrugated metal (CM) gravity drainage pipe through the levee, 10.0 feet below the crown. Flap gate on the waterside (WS) end. Brass cap No. 80 bench mark (BM) on the headwall on the landside (LS). [Additional Reference(s): DWR Levee Log, 2002, (HLM 9.01). USACE San Joaquin O&M Manual, Unit No. 601, Part No. 1, (SJR601.1), 1967, Revised 25 May 2011, (HLM 9.00)]. FS Date: 10/20/2020

LS view: View toward LS toe. Headwall not visible due to high vegetation.

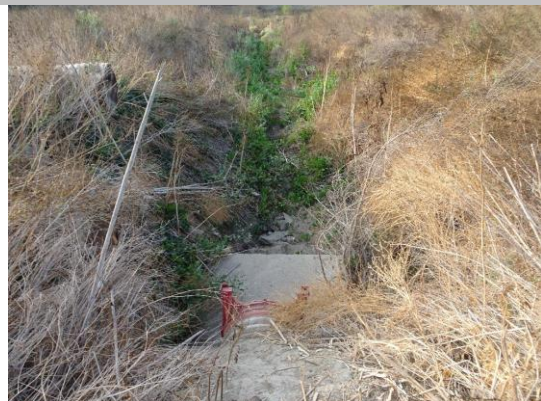
Photo 3 of 3 : UCIP_SP_2024_83466_90914.jpg

Comment Code					
Inspector Comment					
DS_ID:19627 FS_ID:83466 EP_NO: N/A Repair Type: Non-Urgent EVAL Issue: 6, Levee Damage or Threat for Levee Damage Crossing Status: Found UCIP Comments: 12/20/2022 Record updated from Urgent to Non-Urgent. Pipe has been CIPP-lined. LOF of crossing is less or equal to 4. Recommend next video inspection in 5 years. (O.Yakimov - DWR UCIP) 10/21/2020 Record has been updated from Non-Urgent to Urgent. DWR DMP has found integrity issues, LOF between 5 and 6. Scouring observed about 2 feet downstream of pipe at WS toe. Crossing will be monitored until funding becomes available to address. No permit was found authorizing this encroachment. CVFPB will need to review crossing to determine owner. (B. Singh - GEI, O. Magana - DWR UCIP)04/09/2014 Dense vegetation limits the inspector's visibility to identify signs of pipe failure (leaks) along the slope. Recommend removing vegetation along pipe alignment to conduct proper inspection of structure. (W. Wylie - DWR UCIP) FIELD_STRUCT_DESC: 24-inch CIPP-lined corrugated metal (CM) gravity drainage pipe through the levee, 8.6 feet below the crown. Concrete drop inlet at the landside (LS) toe. Flap gate on the waterside (WS) end. Brass cap No. 80 bench mark (BM) on the headwall on the LS. [Additional Reference(s): DWR Levee Log, 2002, (HLM 9.39). USACE San Joaquin O&M Manual, Unit No. 601, Part No. 1, (SJR601.1), 1967, Revised 25 May 2011, (HLM 9.37)]. FS Date: 10/21/2020 8:59:04 AM

WS view: Pipe and flapgate at WS toe

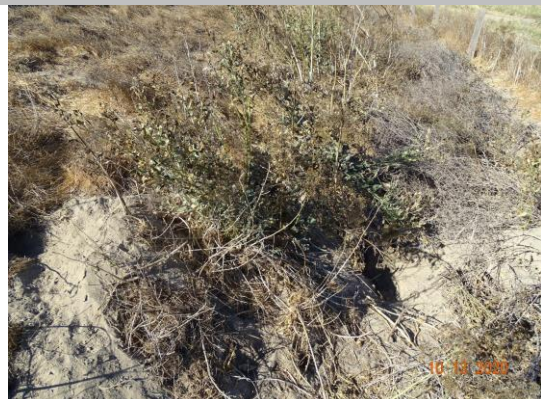
Photo 1 of 1 : SP_2024_NA0010_118_101_20240212_00007.jpg

Rodent burrows in the landside slope. (Fall 2020)

LM Start	9.56	Rating **	M	Issue No.	101
LM End	9.56	Issue Type +	Ma	Location *	LS
Category	Earthen Levee			GPS Latitude/Longitude	
				Start	End
Item	Animal Control			37.295541°	37.295541°
				-120.841739°	-120.841739°
DWR ID	DWR_NA0010_01_f_2020_101				
Comment Code					
A1 : Exterminate rodents and backfill and compact or grout burrows.					
Inspector Comment

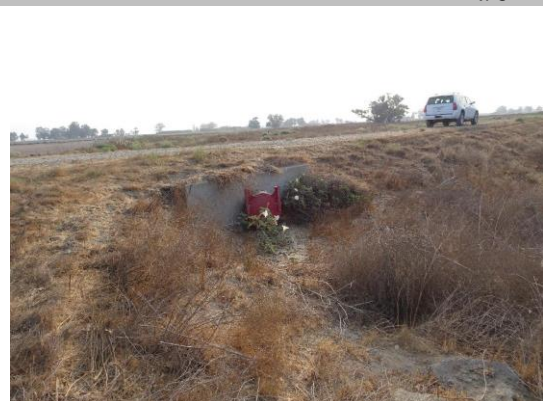
Photo 2 of 3 : UCIP_SP_2024_70678_90917.jpg

Comment Code						
Inspector Comment						
DS_ID:19628 FS_ID:70678 EP_NO: N/A Repair Type: Non-Urgent EVAL Issue: Crossing Status: Found UCIP Comments: 10/21/2020 Record has been updated from No Action Needed to Non-Urgent. No permit was found authorizing this encroachment. CVFPB will need to review crossing to determine owner. DWR DMP has not found internal issues, LOF between 1 and 2. Recommend inspection in 5 years. (B. Singh - GEI, O. Magana - DWR UCIP) FIELD_STRUCT_DESC: 24-inch corrugated metal (CM) gravity drainage pipe through the levee, 4.5 feet below the crown. Flap gate on the waterside (WS) end. Brass cap No. 80 bench mark (BM) on the headwall on the landside (LS). [Additional Reference(s): DWR Levee Log, 2002, (HLM 9.68). USACE San Joaquin O&M Manual, Unit No. 601, Part No. 1, (SJR601.1), 1967, Revised 25 May 2011, (HLM 9.67)]. FS Date: 10/21/2020

WS view: Pipe, flapgate, and headwall at WS toe

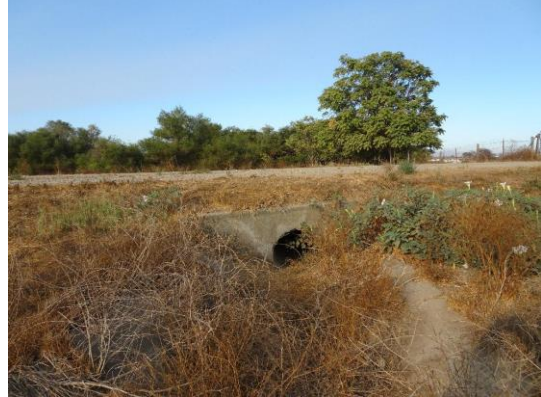
Photo 3 of 3 : UCIP_SP_2024_70678_90920.jpg

LS view: Pipe and headwall at LS toe

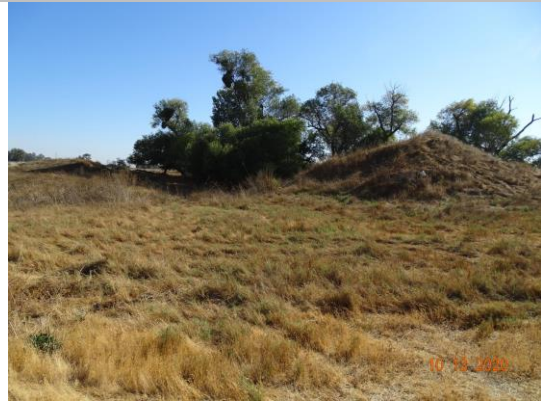
Photo 1 of 1 : SP_2024_NA0010_118_112_20240212_00013.jpg

LM Start	9.89	Rating **	A/W	Issue No.	112
LM End	9.90	Issue Type +	Ma	Location *	CR
Category	Earthen Levee			GPS Latitude/Longitude	
				Start	End
Item	Crown Surface / Depressions / Rutting			37.291796°	37.291581°
				-120.839497°	-120.839718°
DWR ID	DWR_NA0010_01_f_2017_112

Landowner degraded levee in the 1970's because water on LS was flooding his property. Landowner has prevented efforts to restore levee. LMA has stated that no water from the waterside of the levee has ever backed up through the degraded levee and caused flooding.

Looking east at the levee breach. (Fall 2020)

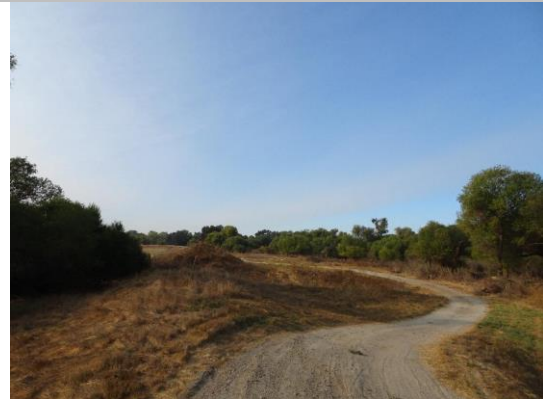
Photo 1 of 3 : UCIP_SP_2024_70680_91045.jpg

DS_ID:19556
FS_ID:70680
EP_NO: N/A
Repair Type: Non-Urgent
EVAL Issue:
Crossing Status: Indicator Found
UCIP Comments: 10/21/2020 Record has been updated from No Action Needed to Non-Urgent. No levee present at this location. This crossing was identified as a System Feature. Pipe not found by visual inspection, only two culverts at grade in the WS. (B. Singh - GEI, O. Magana - DWR UCIP)
FIELD_STRUCT_DESC: 24-inch corrugated metal (CM) gravity drainage pipe through the levee, 6.0 feet below the crown. Flap gate on the waterside (WS) end. Brass cap No. 70 bench mark (BM) on the headwall on the landside (LS). [Additional Reference(s): DWR Levee Log, 2002, (HLM 9.91). USACE San Joaquin O&M Manual, Unit No. 601, Part No. 1, (SJR601.1), 1967, Revised 25 May 2011, (HLM 9.93)].
FS Date: 10/21/2020

Overview of area looking upstream at levee breach.

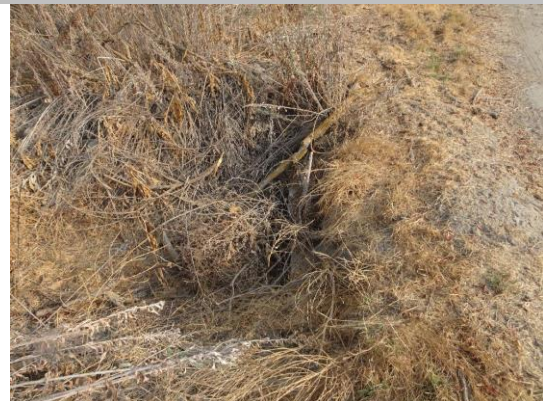
Photo 2 of 3 : UCIP_SP_2024_70680_91047.jpg

Culverts underneath access road visible on WS

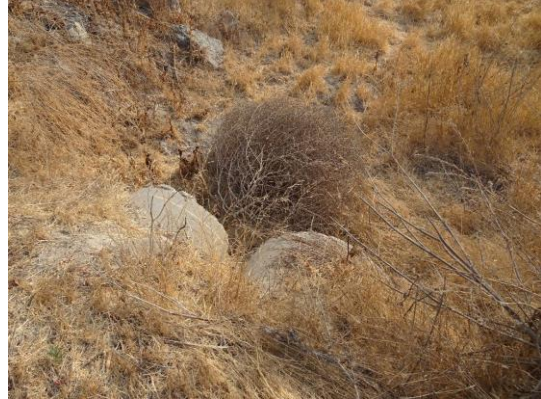
Photo 3 of 3 : UCIP_SP_2024_70680_91049.jpg

Culverts visible past access road.

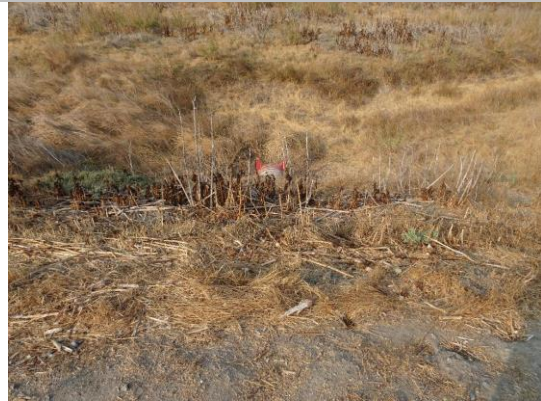
Photo 2 of 3 : UCIP_SP_2024_83246_90923.jpg

Comment Code						
Inspector Comment						
DS_ID:19629 FS_ID:83246 EP_NO: N/A Repair Type: No Action Needed EVAL Issue: Crossing Status: Found UCIP Comments: 04/23/2024 Record updated from Non-Urgent to No Action Needed. DMP internal video inspection has found none or minor pipe defects. (M. Thao - DWR UCIP) 10/21/2020 Record remains Non-Urgent. No permit was found authorizing this encroachment. CVFPB will need to review crossing to determine owner. DWR DMP has not found internal issues, LOF between 1 and 2. Recommend inspection in 5 years. (B. Singh - GEI, O. Magana - DWR UCIP) 04/09/2014 Dense vegetation blocks waterward and landward toes Recommend removing vegetation from both toes. Also sediment buildup in pipe visible from landward side. (W. Wylie - UCIP DMP) FIELD_STRUCT_DESC: 24-inch corrugated metal (CM) gravity drainage pipe through the levee, 9.0 feet below the crown. Flap gate on the waterside (WS) end. Brass cap No. 69 bench mark (BM) on the headwall on the landside (LS). [Additional Reference(s): DWR Levee Log, 2002, (HLM 10.24). USACE San Joaquin O&M Manual, Unit No. 601, Part No. 1, (SJR601.1), 1967, Revised 25 May 2011, (HLM 10.23)]. FS Date: 10/21/2020

WS view: Pipe and flapgate visible at WS toe

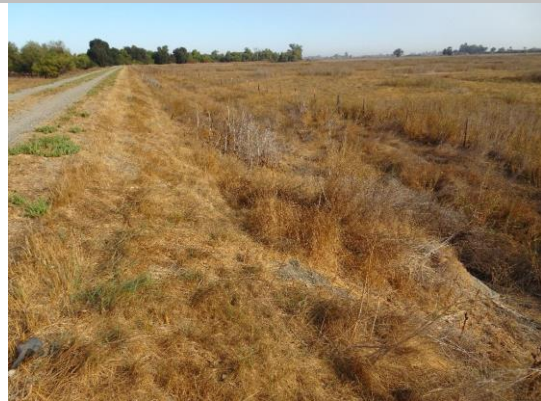
Photo 3 of 3 : UCIP_SP_2024_83246_90925.jpg

LS view: LS toe and pipe headwall

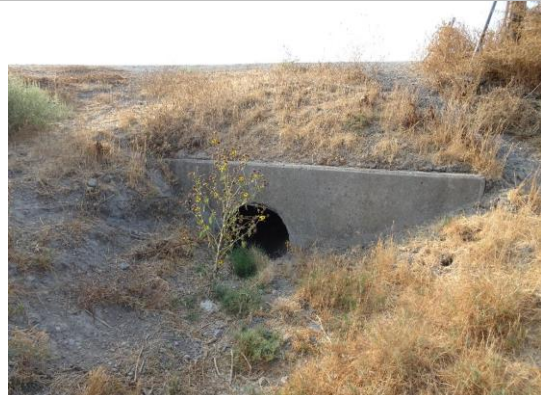
Photo 2 of 2 : UCIP_SP_2024_83254_91003.jpg

LS view: Pipe and headwall at LS toe

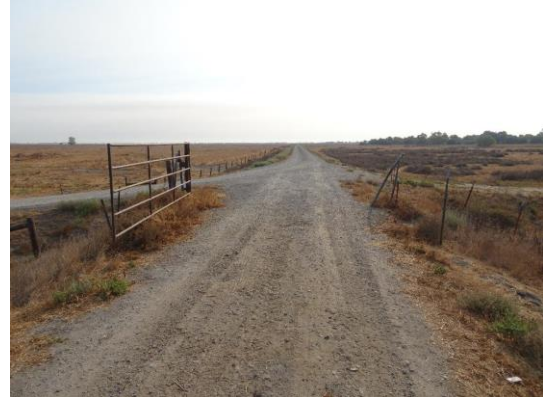
Photo 1 of 3 : UCIP_SP_2024_70683_91009.jpg

Comment Code						
Inspector Comment						
DS_ID:19631 FS_ID:70683 EP_NO: N/A Repair Type: Non-Urgent EVAL Issue: 5, Pipe Damage Crossing Status: Found UCIP Comments: 10/21/2020 Record has been updated from No Action Needed to Non-Urgent. DWR DMP has found integrity issues, LOF between 4 and 5. Crossing will be monitored until funding becomes available for rehabilitation. No permit was found authorizing this encroachment. CVFPB will need to review crossing to determine owner. Pipe material changes from CMP on the WS to concrete on the LS. (B. Singh - GEI, O. Magana - DWR UCIP) FIELD_STRUCT_DESC: 24-inch corrugated metal (CM) gravity drainage pipe through the levee, 7.0 feet below the crown. Flap gate on the waterside (WS) end. Brass cap No. 67 bench mark (BM) on the headwall on the landside (LS). Pipe material changes from CMP on the WS to concrete on the LS. [Additional Reference(s): DWR Levee Log, 2002, (HLM 10.74). USACE San Joaquin O&M Manual, Unit No. 601, Part No. 1, (SJR601.1), 1967, Revised 25 May 2011, (HLM 10.72)]. FS Date: 10/21/2020

Overview of levee crown looking upstream

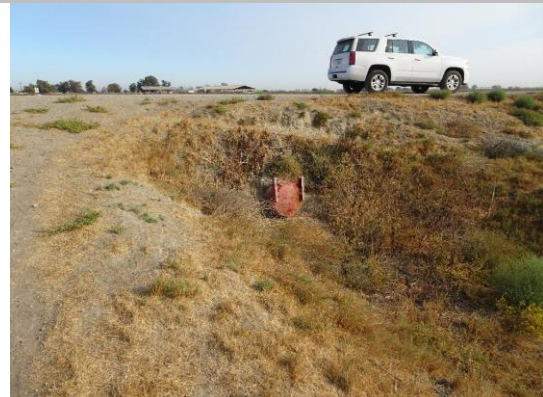
Photo 2 of 3 : UCIP_SP_2024_70683_91010.jpg

WS view: Pipe and flapgate at WS toe

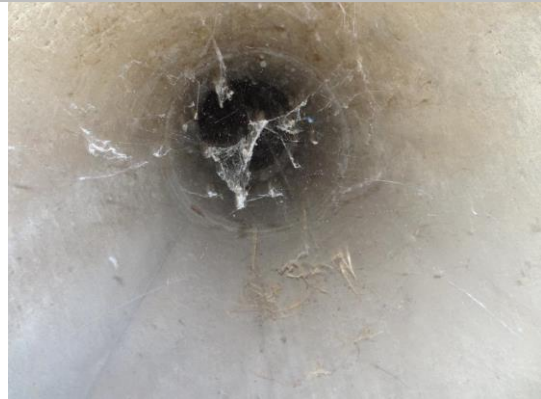
Photo 3 of 3 : UCIP_SP_2024_70683_91013.jpg

LS view: internal view of concrete pipe located on WS.

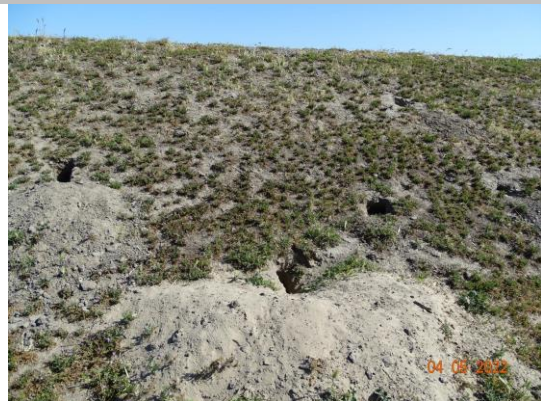
Photo 1 of 1 : SP_2024_NA0010_118_133_20240212_00024.jpg

LM Start	10.90	Rating **	U	Issue No.	133
LM End	10.90	Issue Type +	Ma	Location *	WS
Category	Earthen Levee			GPS Latitude/Longitude	
				Start	End
Item	Animal Control			37.282911 °	37.282911 °
				-120.829665 °	-120.829665 °
DWR ID	DWR_NA0010_01_s_2022_133				
Comment Code					
A3 : No rodents visible, but rodent burrows visible; need to backfill and compact or grout burrows.					
Inspector Comment

View of rodent burrows on the waterside slope. (Spring 2022)

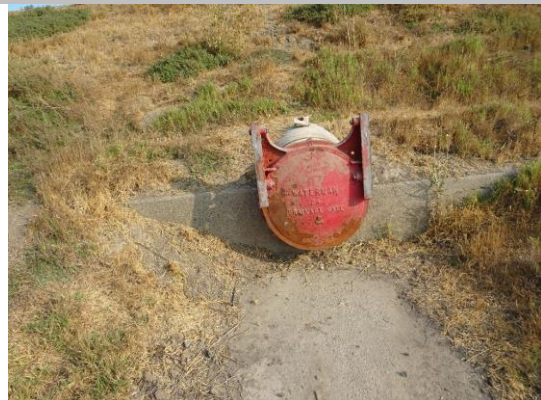
Photo 2 of 3 : UCIP_SP_2024_70684_90933.jpg

WS view: Pipe, flapgate, and headwall at WS toe

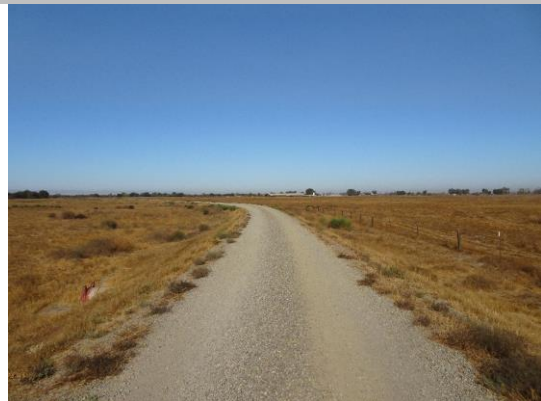
Photo 1 of 3 : UCIP_SP_2024_83255_90935.jpg

Overview of levee crown, looking upstream

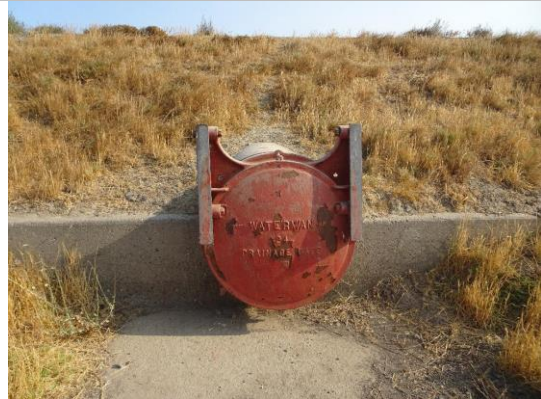
Photo 3 of 3 : UCIP_SP_2024_83255_90934.jpg

WS view: Pipe, flapgate, and headwall at WS toe

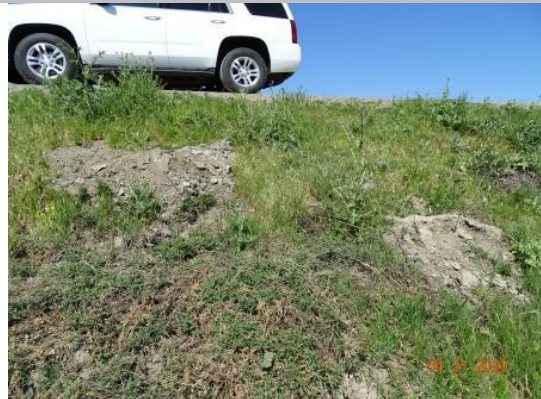
Photo 1 of 1 : SP_2024_NA0010_118_151_20240212_00028.jpg

LM Start	11.37	Rating **	M	Issue No.	151
LM End	11.37	Issue Type +	Ma	Location *	LS
Category	Earthen Levee			GPS Latitude/Longitude	
				Start	End
Item	Animal Control			37.275481°	37.275481°
				-120.826042°	-120.826042°
DWR ID	DWR_NA0010_01_s_2020_151				
Comment Code					
A1 : Exterminate rodents and backfill and compact or grout burrows.					
Inspector Comment

Rodent burrows in the landside slope. (Spring 2020)

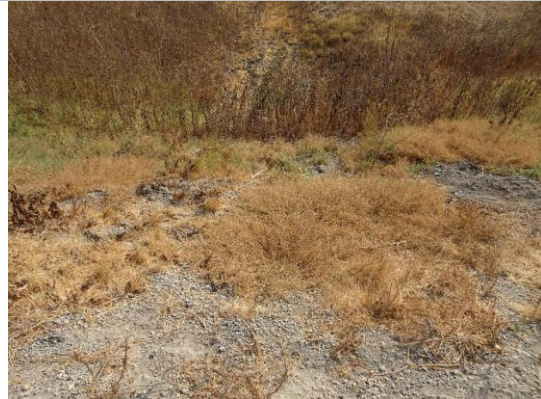
Photo 2 of 3 : UCIP_SP_2024_83256_90943.jpg

LS view: overview of LS slope.

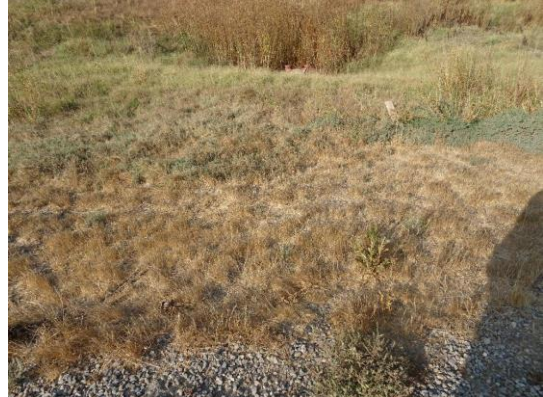
Photo 3 of 3 : UCIP_SP_2024_83256_90942.jpg

WS view: overview of WS slope. Pipe and flapgate visible

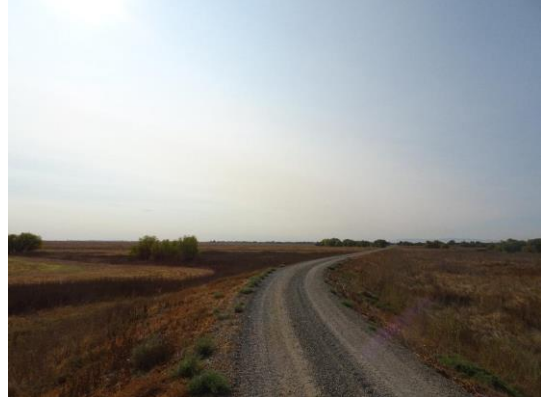
Photo 1 of 3 : UCIP_SP_2024_70687_92836.jpg

Comment Code						
Inspector Comment						
DS_ID:19634 FS_ID:70687 EP_NO: N/A Repair Type: Non-Urgent EVAL Issue: Crossing Status: Found UCIP Comments: 09/18/2023 Pipe was CIPP lined. DMP internal video inspection has found none or minor pipe defects. Recommend next video inspection in 5 years. (O. Yakimov - DWR UCIP) 10/21/2020 Record remains Non-Urgent. Dense vegetation inhibited inspection of pipe and headwall on the LS toe. DWR DMP has found integrity issues, LOF between 4 and 5. Unable to locate pipe inlet on along the LS toe. Crossing will be monitored until funding becomes available for rehabilitation. No permit was found authorizing this encroachment. CVFPB will need to review crossing to determine owner. (B. Singh - GEI, O. Magana - DWR UCIP)04/25/2014 Need to contact owner--landward side has been buried. It appears that soil was removed from levee toe, immediately upstream, and used to pile soil at landward side at crossing. (O. Magana - DWR UCIP) FIELD_STRUCT_DESC: 24-inch CIPP-lined corrugated metal (CM) gravity drainage pipe through the levee, 10.0 feet below the crown. Flap gate on the waterside (WS) end. Brass cap No. 62 bench mark (BM) on the headwall on the landside (LS). [Additional Reference(s): DWR Levee Log, 2002, (HLM 11.48). USACE San Joaquin O&M Manual, Unit No. 601, Part No. 1, (SJR601.1), 1967, Revised 25 May 2011, (HLM 11.48)]. FS Date: 10/21/2020

Overview of levee crown looking upstream towards pipe crossing, photo 1 of 2.

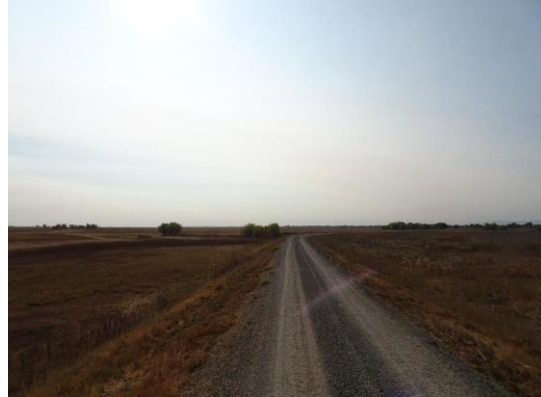
Photo 2 of 3 : UCIP_SP_2024_70687_90946.jpg

Overview of levee crown looking upstream towards pipe crossing, photo 2 of 2.

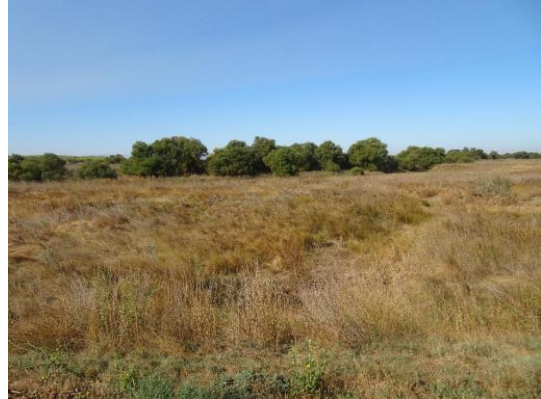
Photo 3 of 3 : UCIP_SP_2024_70687_90947.jpg

WS view: overview of WS.

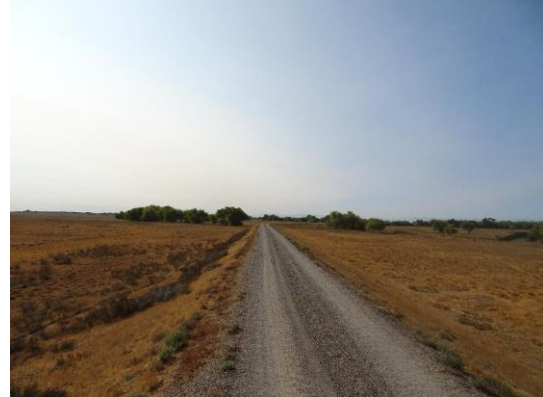
Photo 1 of 3 : UCIP_SP_2024_83257_90950.jpg

Comment Code						
Inspector Comment						
DS_ID:19635 FS_ID:83257 EP_NO: N/A Repair Type: Non-Urgent EVAL Issue: 11, Maintenance Compliance Issue Crossing Status: Found UCIP Comments: 10/21/2020 Record remains Non-Urgent. DWR DMP geophysics study found evidence of pipe at 37.269697, -120.826430 (modified levee mile coordinates 37.269657, -120.826471 using UCIP calculator). Pipe and flap gate previously found on the WS toe were covered by dry vegetation preventing proper UCIP inspection. Recommend removal of excess vegetation to conduct a proper inspection of this structure through the levee. The pipe inlet and concrete headwall are buried on the LS toe. No permit was found authorizing this encroachment. CVFPB will need to review crossing to determine owner. (B. Singh - GEI, O. Magana - DWR UCIP)04/25/2014 Crossing is non-functional --landward side is buried. Debris found on landward side (channel). Dense vegetation found on waterward slope. Recommend contacting owner to determine status of crossing. If crossing is no longer used need to coordinate with CVFPB for proper abandonment. (O. Magana - DWR UCIP) FIELD_STRUCT_DESC: 24-inch corrugated metal (CM) gravity drainage pipe through the levee, 17.0 feet below the crown. Flap gate on the waterside (WS) end. Brass cap No. 61 bench mark (BM) on the headwall on the landside (LS). [Additional Reference(s): DWR Levee Log, 2002, (HLM 11.77). USACE San Joaquin O&M Manual, Unit No. 601, Part No. 1, (SJR601.1), 1967, Revised 25 May 2011, (HLM 11.76)]. FS Date: 10/21/2020

Overview of levee crown

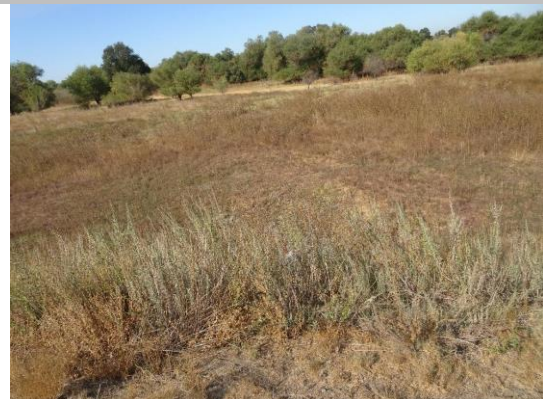
Photo 2 of 3 : UCIP_SP_2024_83274_90960.jpg

WS view: dense vegetation near WS toe.

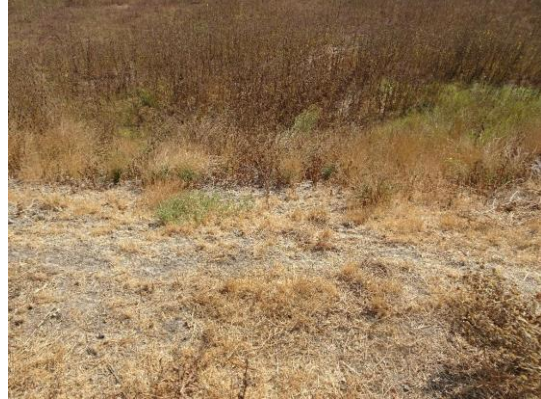
Photo 3 of 3 : UCIP_SP_2024_83274_90961.jpg

LS view: view of LS slope

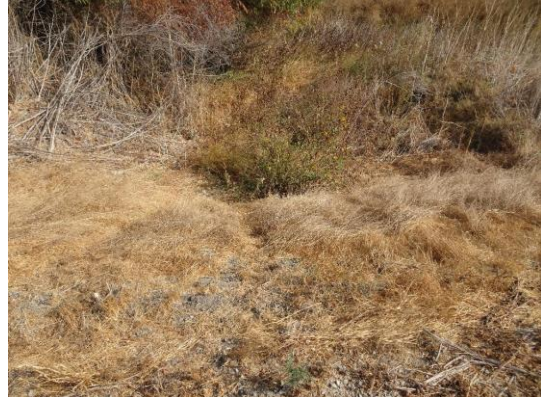
Photo 2 of 3 : UCIP_SP_2024_70690_90964.jpg

Comment Code					
Inspector Comment					
DS_ID:19637 FS_ID:70690 EP_NO: N/A Repair Type: Non-Urgent EVAL Issue: Crossing Status: Found UCIP Comments: 09/15/2023 Pipe was CIPP lined. DMP internal video inspection has found none or minor pipe defects. Recommend next video inspection in 5 years. (O. Yakimov - DWR UCIP) 10/21/2020 Record remains Non-Urgent. DWR DMP has found integrity issues, LOF between 4 and 5. Crossing will be monitored until funding becomes available for rehabilitation. Proper inspection inhibited by dense vegetation. Recommend vegetation removal along pipe alignment. No permit was found authorizing this encroachment. CVFPB will need to review crossing to determine owner. (B. Singh - GEI, O. Magana - DWR UCIP)04/25/2014 Concrete headwall on landward side blocked by debris. Dense vegetation limits the inspector's visibility to identify signs of pipe failure (leaks) along the landward slope. Recommend removing vegetation along pipe alignment to conduct proper inspection of crossing. (O. Magana - DWR UCIP) FIELD_STRUCT_DESC: 24-inch CIPP-lined corrugated metal (CM) gravity drainage pipe through the levee, 9.5 feet below the crown. Flap gate on the waterside (WS) end. Brass cap No. 60 bench mark (BM) on the headwall on the landside (LS). [Additional Reference(s): DWR Levee Log, 2002, (HLM 12.95). USACE San Joaquin O&M Manual, Unit No. 601, Part No. 1, (SJR601.1), 1967, Revised 25 May 2011, (HLM 12.94)]. FS Date: 10/21/2020

LS view: dense vegetation along LS toe. No pipe visible.

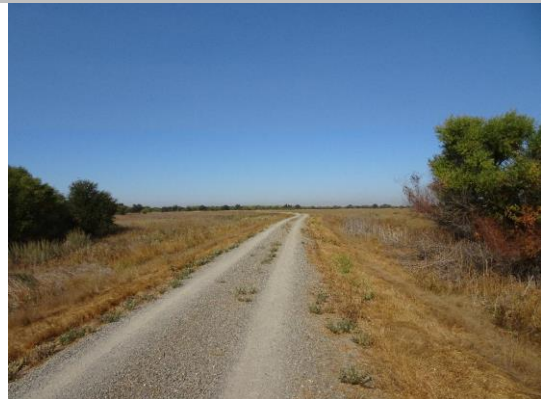
Photo 3 of 3 : UCIP_SP_2024_70690_90962.jpg

Overview of levee crown looking downstream towards pipe crossing.

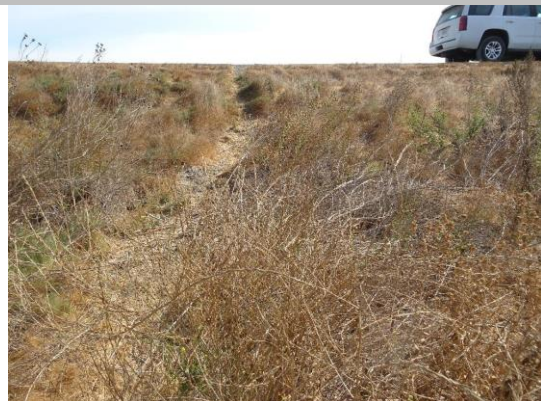
Photo 2 of 2 : UCIP_SP_2024_83258_90970.jpg

LS view: overview of LS slope

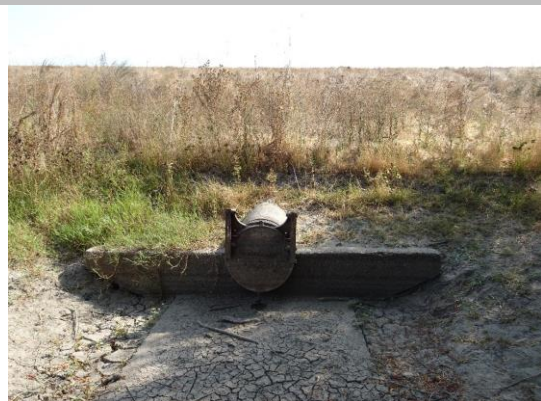
Photo 2 of 3 : UCIP_SP_2024_81163_90974.jpg

WS view: pipe, headwall, and flapgate at WS toe

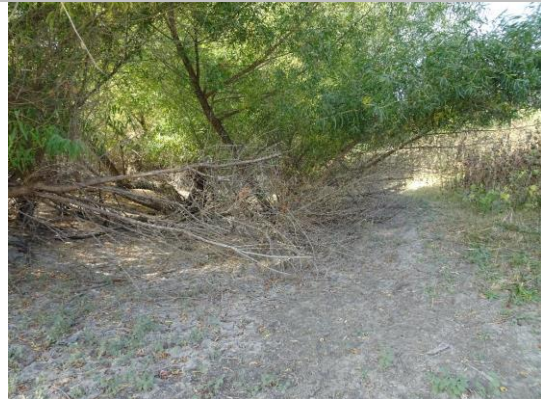
Photo 3 of 3 : UCIP_SP_2024_81163_90975.jpg

WS view: overview looking towards drainage past pipe outlet.

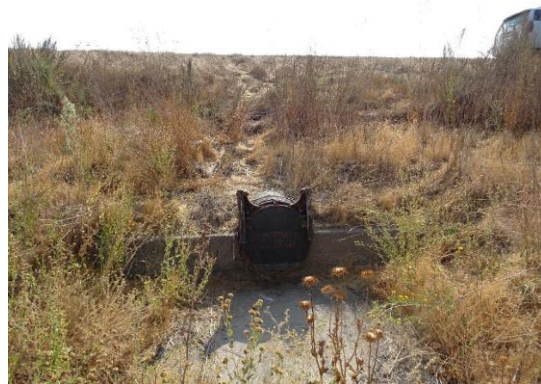
Photo 1 of 3 : UCIP_SP_2024_83261_90984.jpg

DS_ID:19640
FS_ID:83261
EP_NO: N/A
Repair Type: No Action Needed
EVAL Issue:
Crossing Status: Indicator Found
UCIP Comments: 04/24/2024 Record updated from Non-Urgent to No Action Needed. DMP internal video inspection has found none or minor pipe defects. (M. Thao - DWR UCIP)
10/21/2020 Record remains Non-Urgent. No permit was found authorizing this encroachment. CVFPB will need to review crossing to determine owner. DWR DMP has not found internal issues, LOF between 1 and 2. Recommend inspection in 5 years. (B. Singh - GEI, O. Magana - DWR UCIP)
04/25/2014 No photos available--missed crossing. Aerial photograph indicates crossing is present. Need to confirm if crossing is still present on waterward side. (O. Magana - DWR UCIP)
FIELD_STRUCT_DESC: 24-inch corrugated metal (CM) gravity drainage pipe through the levee, 11.0 feet below the crown. Flap gate on the waterside (WS) end. Brass cap No. 60 bench mark (BM) on the headwall on the landside (LS). [Additional Reference(s): DWR Levee Log, 2002, (HLM 13.83). USACE San Joaquin O&M Manual, Unit No. 601, Part No. 1, (SJR601.1), 1967, Revised 25 May 2011, (HLM 13.81)].

WS view: Pipe, flapgate, and headwall at WS toe

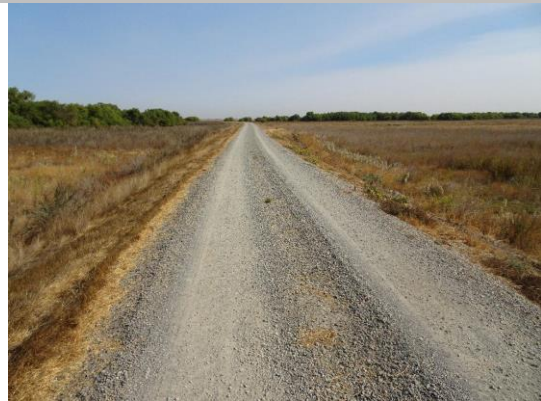
Photo 3 of 3 : UCIP_SP_2024_83261_90977.jpg

Overview of levee crown looking downstream towards crossing.

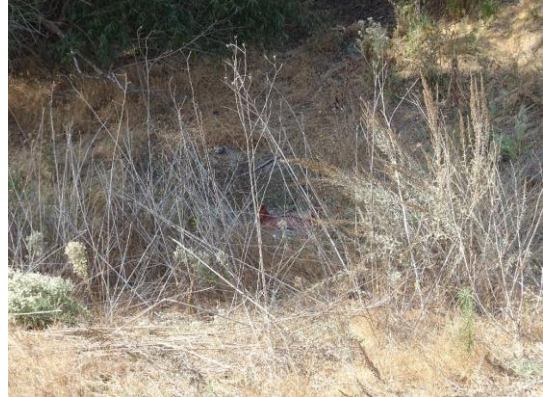
Photo 3 of 3 : UCIP_SP_2024_83262_90985.jpg

WS view: Pipe and flapgate visible through dense vegetation

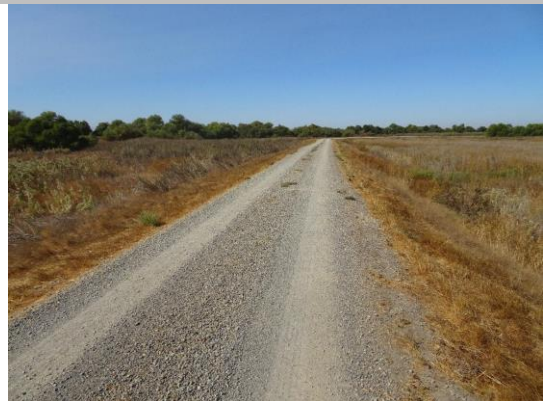
Photo 1 of 3 : UCIP_SP_2024_83263_90992.jpg

DS_ID:19642
FS_ID:83263
EP_NO: N/A
Repair Type: Non-Urgent
EVAL Issue:
Crossing Status: Found
UCIP Comments: 10/21/2020 Record remains Non-Urgent. Dense vegetation along the pipe alignment prevented proper inspection of the levee and pipe. No permit was found authorizing this encroachment. CVFPB will need to review crossing to determine owner. DWR DMP has not found internal issues, LOF between 1 and 2. Recommend inspection in 5 years. (B. Singh - GEI, O. Magana - DWR UCIP)04/25/2014 Dense vegetation limits the inspector's visibility to identify signs of pipe failure (leaks) along the landward slope and toe. Recommend removing vegetation along pipe alignment to conduct proper inspection of structure. (O. Magana - DWR UCIP)
FIELD_STRUCT_DESC: 24-inch corrugated metal (CM) gravity drainage pipe through the levee, 9.7 feet below the crown. Flap gate on the waterside (WS) end. Brass cap No. 60 bench mark (BM) on the headwall on the landside (LS). [Additional Reference(s): DWR Levee Log, 2002, (HLM 14.65). USACE San Joaquin O&M Manual, Unit No. 601, Part No. 1, (SJR601.1), 1967, Revised 25 May 2011, (HLM 14.65)].

Overview of levee crown looking downstream toward crossing.

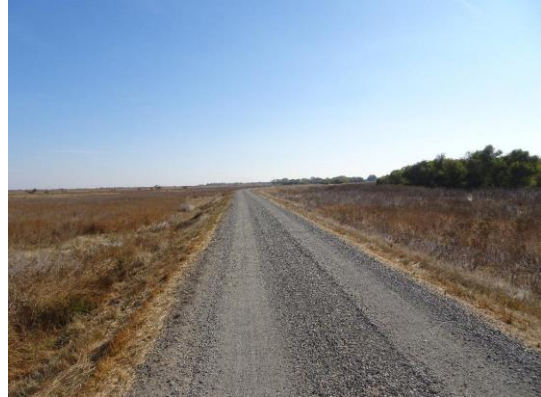
Photo 1 of 3 : UCIP_SP_2024_83264_90792.jpg

Comment Code					
Inspector Comment					
DS_ID:19643 FS_ID:83264 EP_NO: N/A Repair Type: Non-Urgent EVAL Issue: Crossing Status: Found UCIP Comments: 11/16/2020 Record remains Non-Urgent. Dense vegetation on LS toe limited inspection of pipe. Significant burrowing observed on LS and WS slopes. Recommend vegetation removal and rodent mitigation. No permit was found authorizing this encroachment. CVFPB will need to review crossing to determine owner. DWR DMP has not found internal issues, LOF between 1 and 2. Recommend inspection in 5 years. (B. Singh - GEI, O. Magana - DWR UCIP)04/25/2014 Dense vegetation limits the inspector's visibility to identify signs of pipe failure (leaks) along the landward slope. Recommend removing vegetation along pipe alignment to conduct proper inspection of structure. (O. Magana - DWR UCIP) FIELD_STRUCT_DESC: 24-inch corrugated metal (CM) gravity drainage pipe through the levee, 9.2 feet below the crown. Flap gate on the waterside (WS) end. Brass cap No. 60 bench mark (BM) on the headwall on the landside (LS). [Additional Reference(s): DWR Levee Log, 2002, (HLM 15.31). USACE San Joaquin O&M Manual, Unit No. 601, Part No. 1, (SJR601.1), 1967, Revised 25 May 2011, (HLM 15.29)]. FS Date: 11/16/2020

Overview of levee crown, looking US

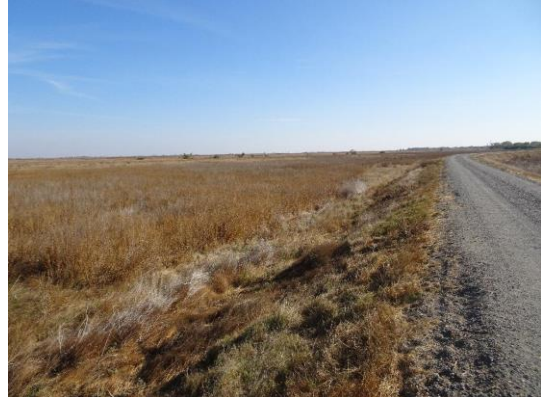
Photo 3 of 3 : UCIP_SP_2024_83264_92867.jpg

LS view: profile view of LS slope

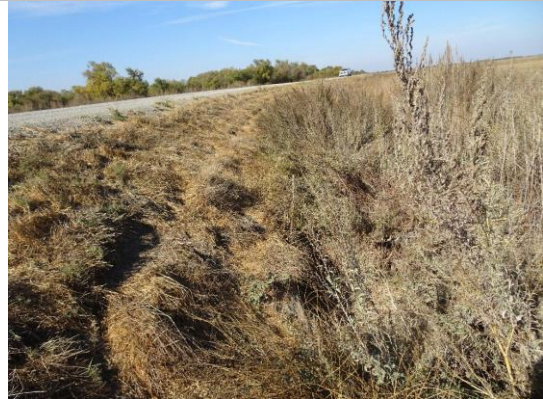
Photo 3 of 3 : UCIP_SP_2024_83265_90799.jpg

LS view: Headwall at LS toe. Dense vegetation inhibited proper inspection of pipe.

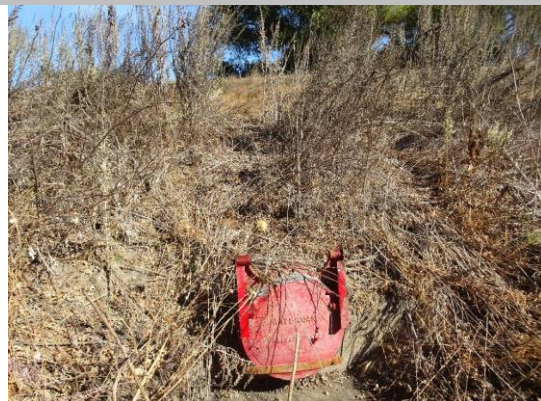
Photo 2 of 3 : UCIP_SP_2024_81164_90806.jpg

WS view: pipe, flapgate, and headwall at WS toe

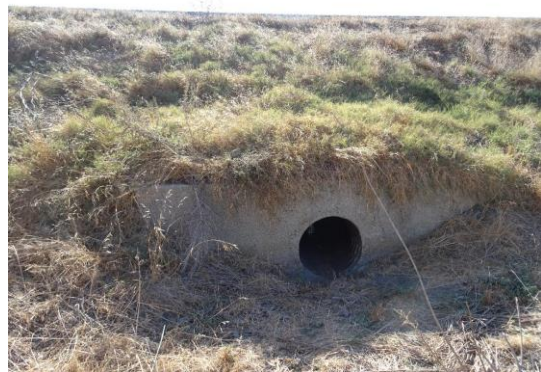
Photo 3 of 3 : UCIP_SP_2024_83267_92964.jpg

LS view: concrete headwall with pipe inlet visible on LS toe.

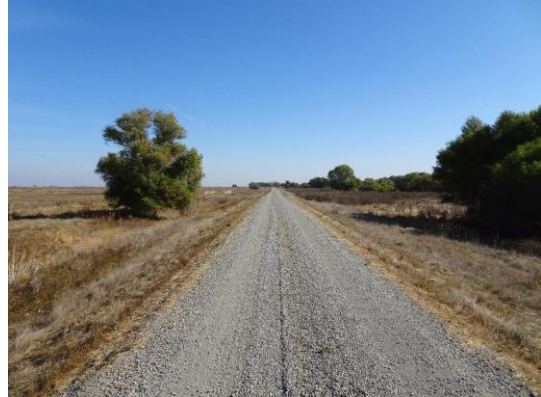
Photo 1 of 3 : UCIP_SP_2024_77854_92979.jpg

Comment Code					
Inspector Comment					
DS_ID:19647 FS_ID:77854 EP_NO: N/A Repair Type: Urgent EVAL Issue: 1, Pipe Integrity Crossing Status: Found UCIP Comments: 12/14/2022 Record updated from Non-Urgent to Urgent. DMP internal video inspection has found pipe integrity issues. LOF of crossing is between 5 and 6. Crossing will be monitored until funding becomes available to address the issues. (O.Yakimov - DWR UCIP) 11/16/2020 Record remains Non-Urgent. Pipe and flapgate on WS toe were under water and there is dense vegetation on the LS slope and toe, inhibiting inspection. No permit was found authorizing this encroachment. CVFPB will need to review crossing to determine owner. DWR DMP internal inspection status is pending. Contacted A. Asrate with DMP staff to find out internal inspection results from 2020. (B. Singh - GEI, O. Magana - DWR UCIP)04/25/2014 Dense vegetation limits the inspector's visibility to identify signs of pipe failure (leaks) along the waterward and landward slopes. Recommend removing vegetation along pipe alignment to conduct proper inspection of structure. Unable to find pipe on landward side. (O. Magana - DWR UCIP) FIELD_STRUCT_DESC: 24-inch corrugated metal (CM) gravity drainage pipe through the levee, 14.7 feet below the crown. Flap gate on the waterside (WS) end. Brass cap No. 50 bench mark (BM) on the headwall on the landside (LS). [Additional Reference(s): DWR Levee Log, 2002, (HLM 16.16). USACE San Joaquin O&M Manual, Unit No. 601, Part No. 1, (SJR601.1), 1967, Revised 25 May 2011, (HLM 16.15)]. FS Date: 11/16/2020 1:38:40 PM

Overview of levee crown looking upstream towards pipe crossing.

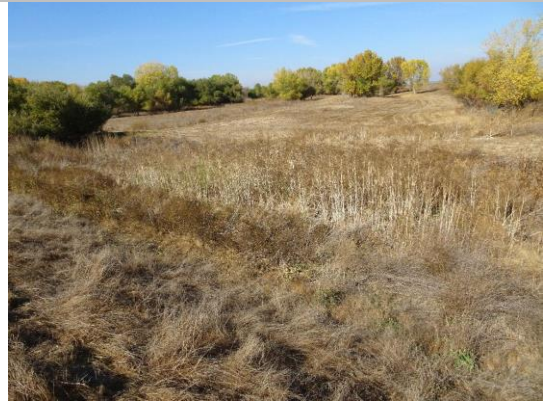
Photo 2 of 3 : UCIP_SP_2024_77854_92980.jpg

LS view: overview of LS.

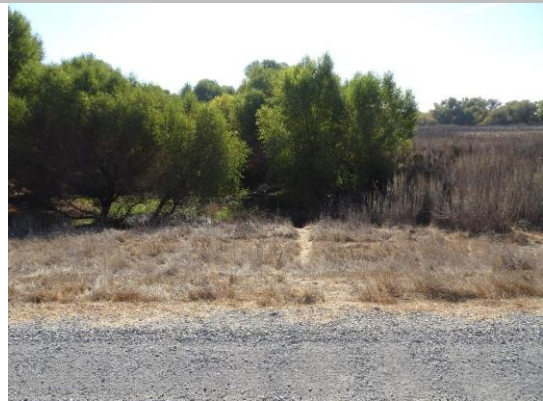
Photo 3 of 3 : UCIP_SP_2024_77854_92978.jpg

WS view: overview of WS.

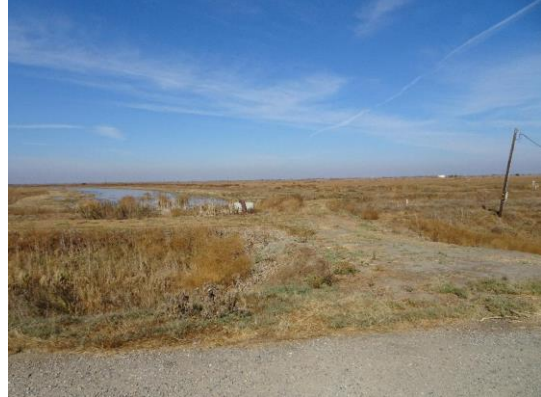
Photo 3 of 3 : UCIP_SP_2024_70701_90815.jpg

LS view: overview of LS. Concrete cone with 12" pipe found.

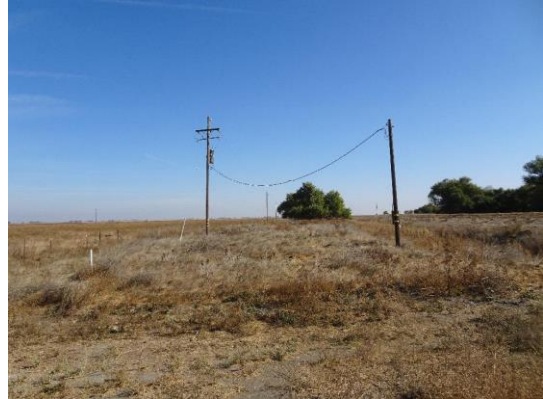
Photo 3 of 3 : UCIP_SP_2024_81165_90823.jpg

LS view: view from LS toe, looking US. Pipe and headwall not found on LS toe.

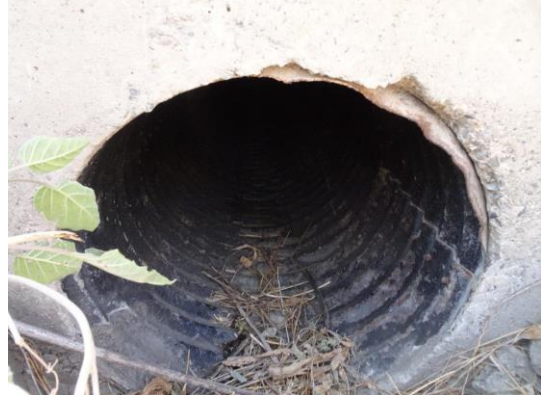
Photo 3 of 3 : UCIP_SP_2024_83268_90829.jpg

LS view: minor damage to headwall concrete at inlet on LS toe.

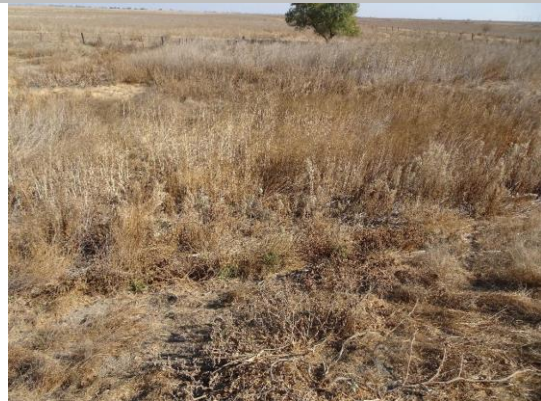
Photo 3 of 3 : UCIP_SP_2024_83270_93005.jpg

LS view: dense vegetation along LS toe.

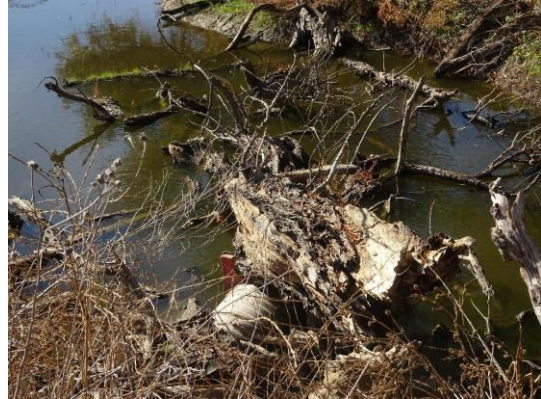
Photo 3 of 3 : UCIP_SP_2024_81000_90837.jpg

DS_ID:19579
FS_ID:81000
EP_NO: N/A
Repair Type: Urgent
EVAL Issue: 1, Pipe Integrity
Crossing Status: Found
UCIP Comments: 09/15/2023 Record updated from Non-Urgent to Urgent. DMP internal video inspection has found severe pipe defects. Crossing will be monitored until funding becomes available to address the issues. (O. Yakimov - DWR UCIP)
11/16/2020 Record remains Non-Urgent. Debris is blocking flapgate on the WS inlet. No permit was found authorizing this encroachment. CVFPB will need to review crossing to determine owner. DWR DMP internal inspection is pending and scheduled for 2021. (B. Singh - GEI, O. Magana - DWR UCIP)04/25/2014 Dense vegetation limits the inspector's visibility to identify signs of pipe failure (leaks) along the waterward and landward slope. Recommend removing vegetation along pipe alignment to conduct proper inspection of structure. (O. Magana - DWR UCIP)
FIELD_STRUCT_DESC: 24-inch corrugated metal (CM) gravity drainage pipe through the levee, 15.8 feet below the crown. Flap gate on the waterside (WS) end. Brass cap No. 50 bench mark (BM) on the headwall on the landside (LS). [Additional Reference(s): DWR Levee Log, 2002, (HLM 17.27). USACE San Joaquin O&M Manual, Unit No. 601, Part No. 1, (SJR601.1), 1967, Revised 25 May 2011, (HLM 17.26)]. FS Date: 11/16/2020

WS view: debris blocking pipe flapgate at WS toe.
