Flood Control Project Maintenance
Levee Inspections
LMA District Cover Sheet

Lower San Joaquin Levee District

**Flood Control Project Maintenance
Levee Inspections
Unit Cover Sheet**

Levee Inspection Report By Mile - Spring 2024

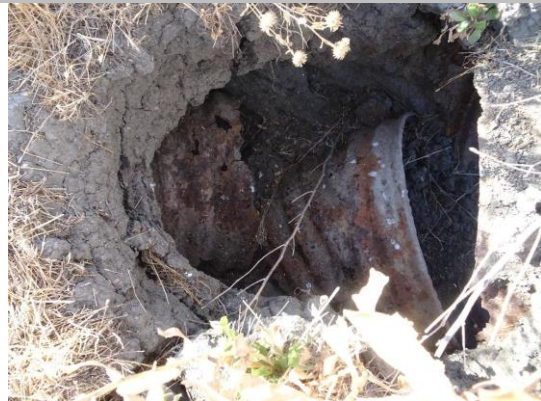
Photo 3 of 3 : UCIP_SP_2024_70707_90838.jpg

DS_ID:19580
FS_ID:70707
EP_NO: N/A
Repair Type: Urgent
EVAL Issue: 1, Pipe Integrity
Crossing Status: Found
UCIP Comments: 11/16/2020 Record has been updated from Non-Urgent to Urgent. Pipe in failed condition on the LS. Potential sink hole located about 1 foot from the LS toe. No permit was found authorizing this encroachment. CVFPB will need to review crossing to determine owner. DWR DMP internal inspection is pending and scheduled for 2021. (B. Singh - GEI, O. Magana - DWR UCIP)04/25/2014 Dense vegetation limits the inspector's visibility to identify signs of pipe failure (leaks) along the landward slope. Recommend removing vegetation along pipe alignment to conduct proper inspection of structure. (O. Magana - DWR UCIP)
FIELD_STRUCT_DESC: 24-inch corrugated metal (CM) gravity drainage pipe through the levee, 9.5 feet below the crown. Flap gate on the waterside (WS) end. Brass cap No. 50 bench mark (BM) on the headwall on the landside (LS). [Additional Reference(s): DWR Levee Log, 2002, (HLM 17.53). USACE San Joaquin O&M Manual, Unit No. 601, Part No. 1, (SJR601.1), 1967, Revised 25 May 2011, (HLM 17.53)].

LS view: Pipe collapse visible in sinkhole along pipe alignment, photo 2 of 2.

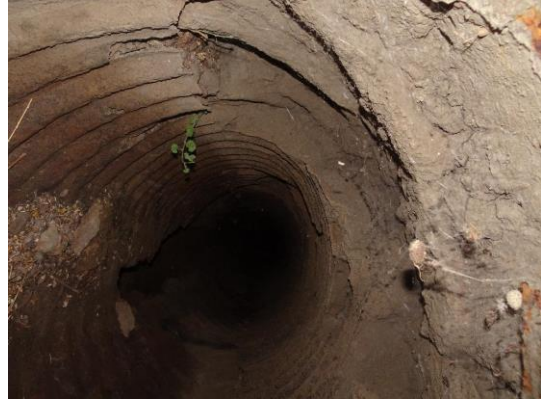
Photo 3 of 3 : UCIP_SP_2024_70708_90848.jpg

Comment Code					
Inspector Comment					
DS_ID:19581 FS_ID:70708 EP_NO: N/A Repair Type: Urgent EVAL Issue: 1, Pipe Integrity Crossing Status: Found UCIP Comments: 11/16/2020 Record has been updated from Non-Urgent to Urgent. Considerable damage to the pipe interior is visible from LS toe. DWR DMP has found integrity issues, LOF between 5 and 6. Crossing will be monitored until funding becomes available to address. No permit was found authorizing this encroachment. CVFPB will need to review crossing to determine owner. (B. Singh - GEI, O. Magana - DWR UCIP)04/25/2014 Need to contact owner. Recommend investigating integrity of pipe wall through levee heavy corrosion visible from landward side. (O. Magana - DWR UCIP) FIELD_STRUCT_DESC: 24-inch corrugated metal (CM) gravity drainage pipe through the levee, 11.5 feet below the crown. Flap gate on the waterside (WS) end. Brass cap No. 50 bench mark (BM) on the headwall on the landside (LS). [Additional Reference(s): DWR Levee Log, 2002, (HLM 18.21). USACE San Joaquin O&M Manual, Unit No. 601, Part No. 1, (SJR601.1), 1967, Revised 25 May 2011, (HLM 18.19)]. FS Date: 11/16/2020

LS view: Considerable damage observed at LS inlet

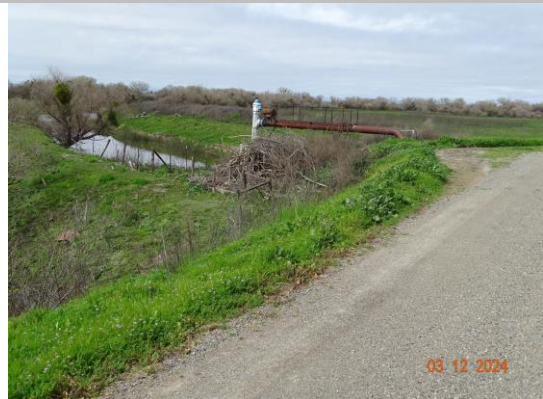
Photo 1 of 1 : SP_2024_NA0010_118_134_20240326_00258.jpg

LM Start	18.77	Rating **	U	Issue No.	134
LM End	18.77	Issue Type +	En	Location *	WS
Category	Earthen Levee			GPS Latitude/Longitude	
				Start	End
Item	Encroachments			37.205064 °	37.205064 °
				-120.762721 °	-120.762721 °
DWR ID	DWR_NA0010_01_s_ 2019_134				
Comment Code					
PR : Prunings					
Inspector Comment

View of pruning pile on the waterside slope. (Spring 2024)

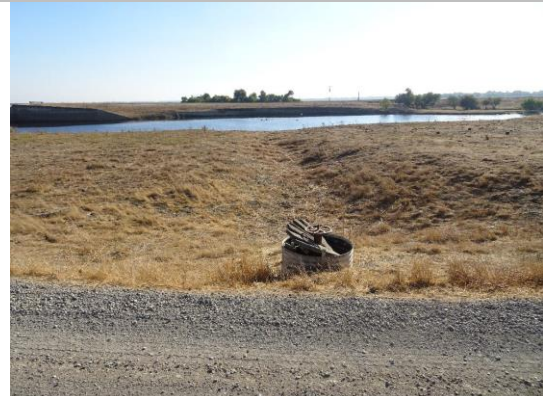
Photo 2 of 3 : UCIP_SP_2024_70712_90862.jpg

DS_ID:19594
FS_ID:70712
EP_NO: N/A
Repair Type: Non-Urgent
EVAL Issue: 11, Maintenance Compliance Issue
Crossing Status: Found
UCIP Comments: 11/16/2020 Record remains Non-Urgent. Unable to locate pipe on the WS. Pipe appears to be buried on WS. Sediment build-up observed at the LS inlet. Recommend sediment removal and evaluation of pipe's purpose. Pipe is currently non-functional. No permit was found authorizing this encroachment. CVFPB will need to review crossing to determine owner. DWR DMP internal inspection is pending and scheduled for 2021. Recommend adding riser cover on the WS as a safety measure. (B. Singh - GEI, O. Magana - DWR UCIP)04/25/2014 Non-functional crossing--pipe is buried on waterward side. Sediment buildup in pipe visible from landward side. Need to coordinate with owner to determine status. If crossing is no longer in use, owner will need to coordinate with DWR Inspector and CVFPB to properly abandon. (O. Magana - DWR UCIP)

Pipe riser visible on WS slope

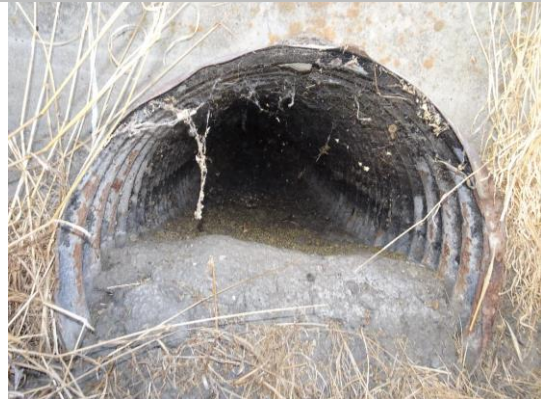
Photo 3 of 3 : UCIP_SP_2024_70712_90857.jpg

Considerable sediment build-up at LS inlet

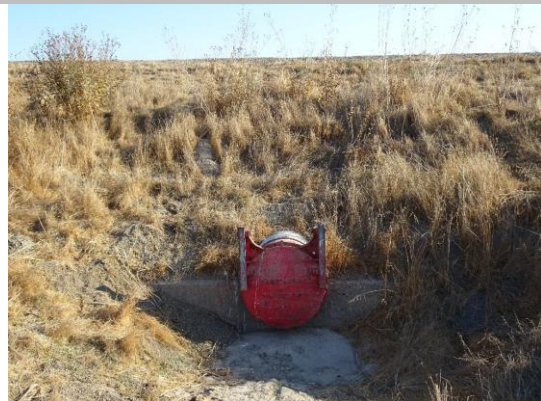
Photo 1 of 2 : UCIP_SP_2024_83271_90889.jpg

DS_ID:19596
 FS_ID:83271
 EP_NO: N/A
 Repair Type: No Action Needed
 EVAL Issue:
 Crossing Status: Found
 UCIP Comments: 11/16/2020 Record remains Non-Urgent. No permit was found authorizing this encroachment. CVFPB will need to review crossing to determine owner. DWR DMP has not found internal issues, LOF between 1 and 2. Recommend inspection in 5 years. (B. Singh - GEI, O. Magana - DWR UCIP)04/25/2014 Dense vegetation limits the inspector's visibility to identify signs of pipe failure (leaks) along the waterward slope. Recommend removing vegetation along pipe alignment to conduct proper inspection of structure. Dense vegetation blocks both waterward and landward headwalls. Sediment buildup in pipe visible from landward side. (O. Magana - DWR UCIP)
 FIELD_STRUCT_DESC: 24-inch corrugated metal (CM) gravity drainage pipe through the levee, 8.0 feet below the crown. Flap gate on the waterside (WS) end. Brass cap No. 40 bench mark (BM) on the headwall on the landside (LS). [Additional Reference(s): DWR Levee Log, 2002, (HLM 19.54). USACE San Joaquin O&M Manual, Unit No. 601, Part No. 1, (SJR601.1), 1967, Revised 25 May 2011, (HLM 19.54)].

WS view: concrete headwall, flap gate, and WS slope visible on WS.

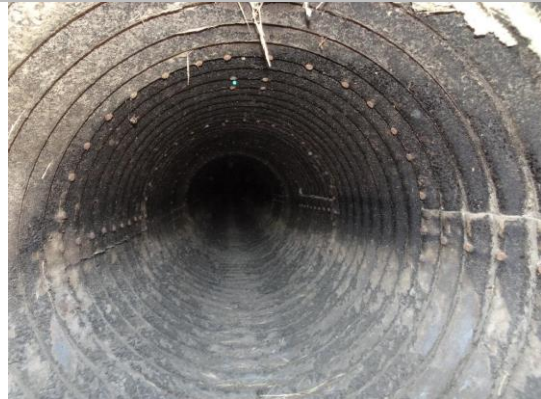
Photo 2 of 2 : UCIP_SP_2024_83271_90894.jpg

LS view: Interior of pipe from LS toe

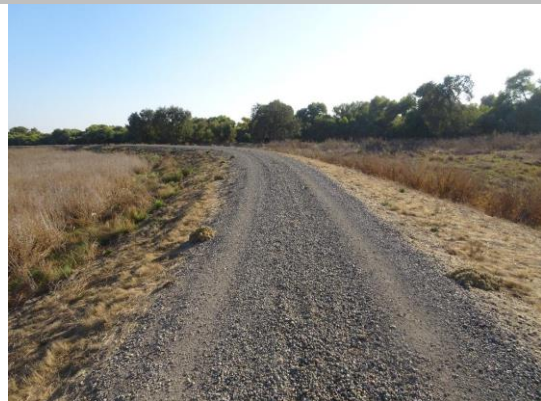
Photo 1 of 3 : UCIP_SP_2024_83272_90896.jpg

DS_ID:19597
FS_ID:83272
EP_NO: N/A
Repair Type: No Action Needed
EVAL Issue:
Crossing Status: Found
UCIP Comments: 04/24/2024 Record updated from Non-Urgent to No Action Needed. DMP internal video inspection has found none or minor pipe defects. (M. Thao - DWR UCIP)
11/16/2020 Record remains Non-Urgent. No permit was found authorizing this encroachment. CVFPB will need to review crossing to determine owner. DWR DMP internal inspection is pending and scheduled for 2021. (B. Singh - GEI, O. Magana - DWR UCIP)
04/25/2014 No photos available for crossing--crossing missed. Recommend taking photos to confirm status of crossing. (O. Magana - DWR UCIP)
FIELD_STRUCT_DESC: 24-inch corrugated metal (CM) gravity drainage pipe through the levee, 8.0 feet below the crown. Flap gate on the waterside (WS) end. Brass cap No. 40 bench mark (BM) on the headwall on the landside (LS). [Additional Reference(s): DWR Levee Log, 2002, (HLM 19.82). USACE San Joaquin O&M Manual, Unit No. 601, Part No. 1, (SJR601.1), 1967, Revised 25 May 2011, (HLM 19.81)].

Overview of levee crown looking u/s

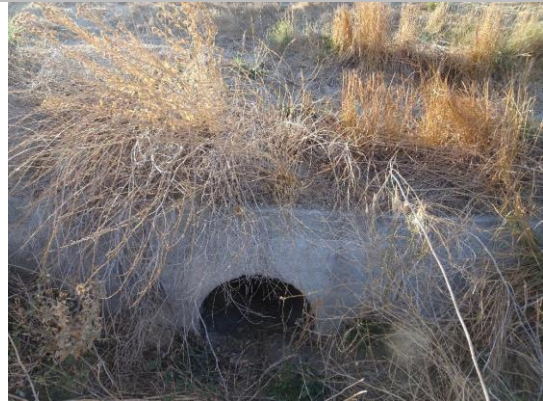
Photo 2 of 3 : UCIP_SP_2024_83272_90899.jpg

LS view: pipe and headwall at LS toe

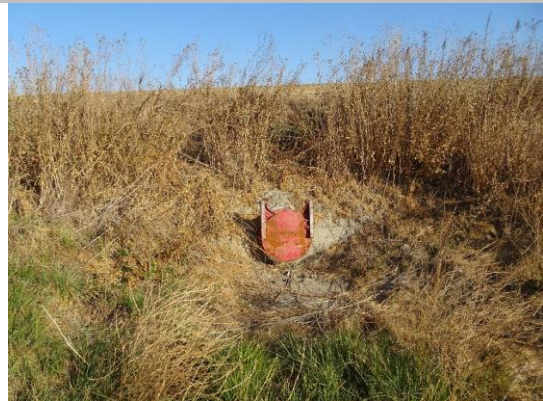
Photo 3 of 3 : UCIP_SP_2024_83272_90902.jpg

WS view: Pipe, flapgate, and headwall at WS toe

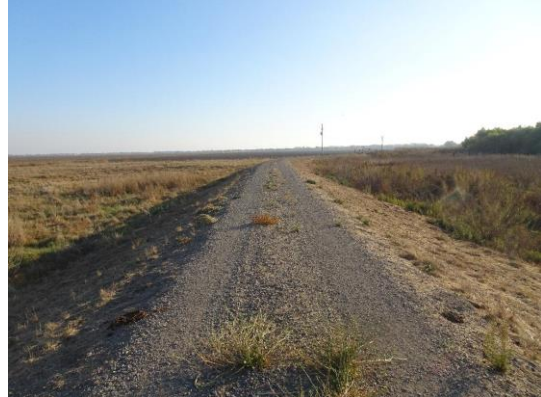
Photo 1 of 3 : UCIP_SP_2024_83273_90903.jpg

Comment Code						
Inspector Comment						
DS_ID:19598 FS_ID:83273 EP_NO: N/A Repair Type: Non-Urgent EVAL Issue: Crossing Status: Found UCIP Comments: 11/16/2020 Record remains Non-Urgent. Limited access due to steep slopes. No permit was found authorizing this encroachment. CVFPB will need to review crossing to determine owner. DWR DMP internal inspection is pending and scheduled for 2021. (B. Singh - GEI, O. Magana - DWR UCIP)04/25/2014 Recommend removing vegetation and sediment buildup from both waterward and landward concrete headwalls. (O. Magana - DWR UCIP) FIELD_STRUCT_DESC: 24-inch corrugated metal (CM) gravity drainage pipe through the levee, 8.5 feet below the crown. Flap gate on the waterside (WS) end. Brass cap No. 40 bench mark (BM) on the headwall on the landside (LS). [Additional Reference(s): DWR Levee Log, 2002, (HLM 20.19). USACE San Joaquin O&M Manual, Unit No. 601, Part No. 1, (SJR601.1), 1967, Revised 25 May 2011, (HLM 20.18)]. FS Date: 11/16/2020

Overview of levee crown looking upstream

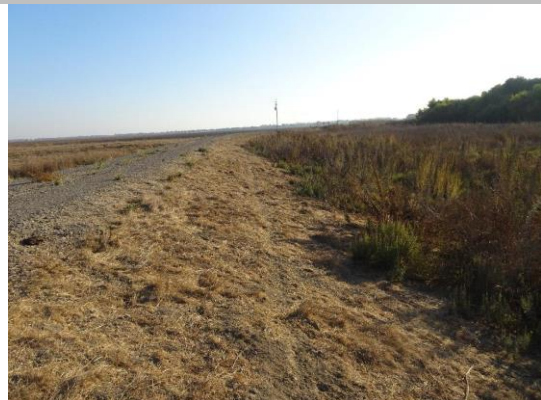
Photo 2 of 3 : UCIP_SP_2024_83273_90904.jpg

WS view: WS slope profile

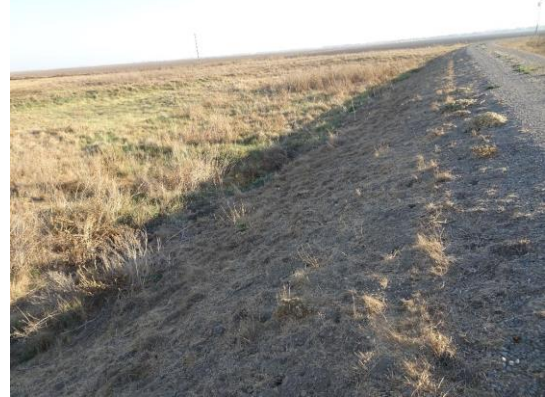
Photo 3 of 3 : UCIP_SP_2024_83273_90905.jpg

LS view: LS slope profile

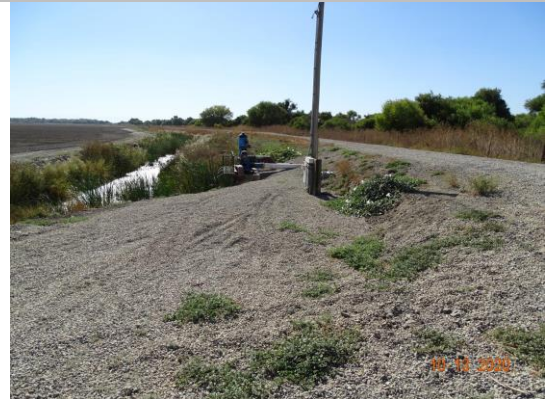
Photo 1 of 1 : SP_2024_NA0010_118_1184_20240212_00029.jpg

LM Start	20.25	Rating **	A/W	Issue No.	1184
LM End	20.25	Issue Type +	En	Location *	LS
Category	Earthen Levee			GPS Latitude/Longitude	
				Start	End
Item	Encroachments			37.193657°	37.193657°
				-120.760138°	-120.760138°
DWR ID	DWR_NA0010_01_s_2015_1184				
Comment Code					
RA : Ramp					
Inspector Comment					
Landowner installed unauthorized ramp on landside slope and toe.

Ramp cut into to the landside slope to access irrigation ditch at the landside toe. (Fall 2020)

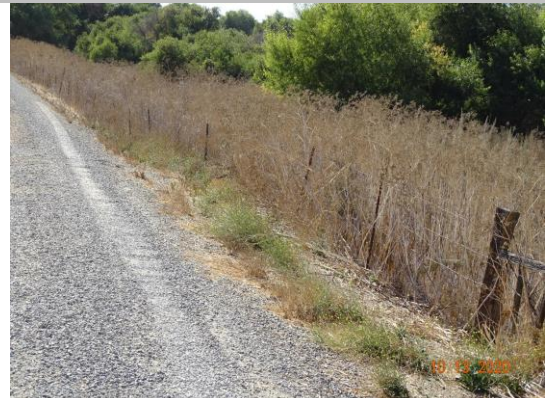
Photo 1 of 1 : SP_2024_NA0010_118_106_20240212_00009.jpg

LM Start	20.25	Rating **	M	Issue No.	106
LM End	22.51	Issue Type +	En	Location *	WS
Category	Earthen Levee			GPS Latitude/Longitude	
				Start	End
Item	Encroachments			37.193663°	37.166957°
				-120.760148°	-120.750080°
DWR ID	DWR_NA0010_01_f_2020_106				
Comment Code					
FE : Fence					
Inspector Comment

Barbed wire fence along the waterside slope. (Fall 2020)

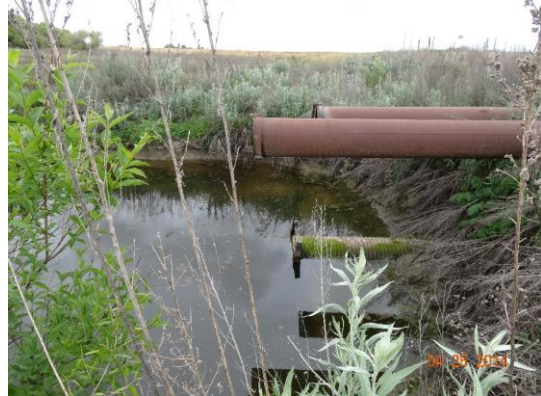
Photo 1 of 2 : UCIP_SP_2024_70721_66309.jpg

DS_ID:19600
FS_ID:70721
EP_NO: N/A
Repair Type: Non-Urgent
EVAL Issue:
Crossing Status: Found
UCIP Comments: 11/16/2020 Record remains Non-Urgent. Dense vegetation and fence on the WS prevented proper inspection of pipe. No permit has been found authorizing this pipe. CVFPB will need to review crossing to determine owner. (O. Magana - DWR UCIP)04/25/2014 Crossing partially submersed--no signs of failure of pipe present along pipe alignment. Recommend contacting owner to determine status of crossing and condition. (O. Magana - DWR UCIP) FIELD_STRUCT_DESC: 36-inch corrugated metal (CM) gravity drainage pipe through the levee, 10.5 feet below the crown. Flap gate on the waterside (WS) end. Brass cap No. 40 bench mark (BM) on the headwall on the landside (LS). [Additional Reference(s): DWR Levee Log, 2002, (HLM 20.28). USACE San Joaquin O&M Manual, Unit No. 601, Part No. 1, (SJR601.1), 1967, Revised 25 May 2011, (HLM 20.27)]. FS Date: 11/6/2020

Multiple crossings visible on waterward side--36 inch CMP is submersed in water.

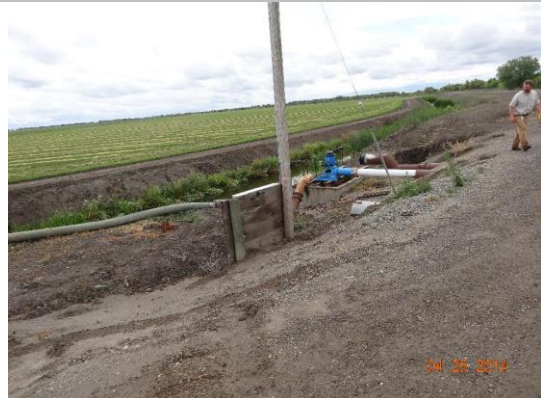
Photo 2 of 2 : UCIP_SP_2024_70721_66307.jpg

View of landward side.

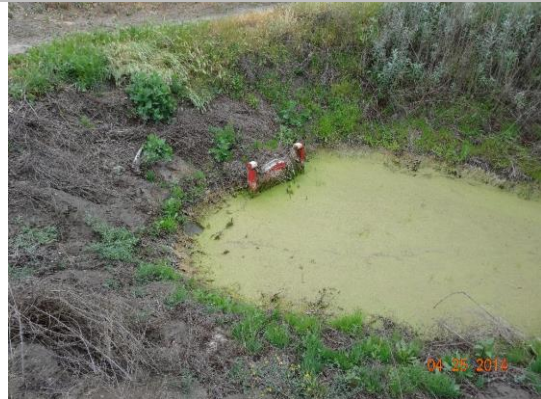
Photo 1 of 3 : UCIP_SP_2024_80999_66313.jpg

DS_ID:19603
FS_ID:80999
EP_NO: N/A
Repair Type: Urgent
EVAL Issue: 1, Pipe Integrity
Crossing Status: Found
UCIP Comments: 09/15/2023 Record updated from Non-Urgent to Urgent. DMP internal video inspection has found severe pipe defects. Crossing will be monitored until funding becomes available to address the issues. (O. Yakimov - DWR UCIP)
05/06/2021 Record remains Non-Urgent. This crossing appears to be non-functional based on the 2014 UCIP inspection. No field inspection has been completed by UCIP. DWR DMP internal inspection is pending and scheduled for 2021. Recommend having UCIP inspector or Levee inspector take current photos of the site. (O. Magana - DWR UCIP)04/25/2014 Crossing is non-functional--crossing buried on landward side. Need to contact owner to determine status of crossing. If crossing is no longer used need to coordinate with CVFPB for proper abandonment. (O. Magana - DWR UCIP)

Flap gate half way submersed located on waterward side.

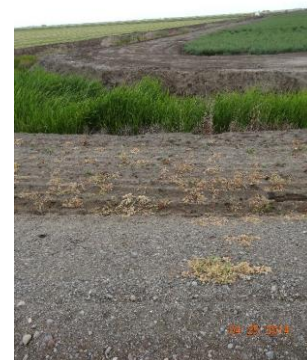
Photo 2 of 3 : UCIP_SP_2024_80999_66311.jpg

View of landward side.

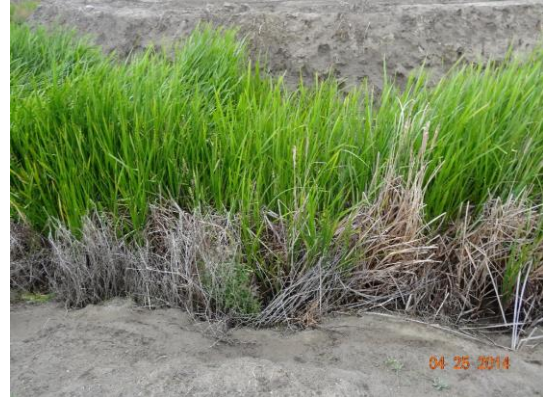
Photo 3 of 3 : UCIP_SP_2024_80999_66310.jpg

No signs of concrete headwall on landward toe.

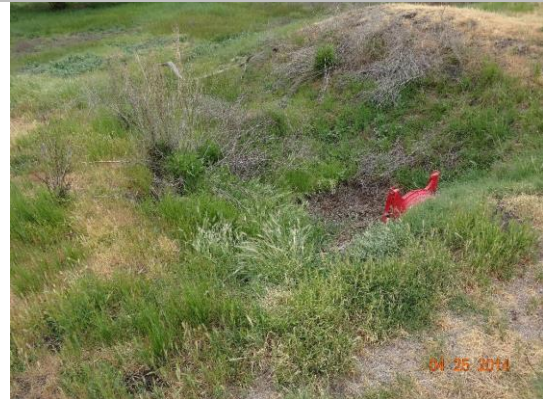
Photo 1 of 2 : UCIP_SP_2024_77848_65695.jpg

Comment Code						
Inspector Comment						
DS_ID:19604 FS_ID:77848 EP_NO: N/A Repair Type: Urgent EVAL Issue: 1, Pipe Integrity Crossing Status: Found UCIP Comments: 12/14/2022 Record updated from Non-Urgent to Urgent. DMP internal video inspection has found pipe integrity issues. LOF of crossing is between 5 and 6. Crossing will be monitored until funding becomes available to address the issues. (O.Yakimov - DWR UCIP) 05/06/2021 Record remains Non-Urgent. This crossing appears to be non-functional based on the 2014 UCIP inspection. No field inspection has been completed by UCIP. DWR DMP internal inspection is pending and scheduled for 2021. Recommend having UCIP inspector or Levee inspector take current photos of the site. (O. Magana - DWR UCIP)04/25/2014 Non-functional crossing-landward side is buried. Need to contact owner to determine status of crossing. If crossing is no longer used need to coordinate with CVFPB for proper abandonment. (O. Magana - DWR UCIP) FIELD_STRUCT_DESC: 24-inch corrugated metal (CM) gravity drainage pipe through the levee, 9.0 feet below the crown. Flap gate on the waterside (WS) end. Brass cap No. 40 bench mark (BM) on the headwall on the landside (LS). [Additional Reference(s): DWR Levee Log, 2002, (HLM 21.78). USACE San Joaquin O&M Manual, Unit No. 601, Part No. 1, (SJR601.1), 1967, Revised 25 May 2011, (HLM 21.76)]. FS Date: 5/6/2021 1:29:33 PM

Flap gate visible on waterward side.

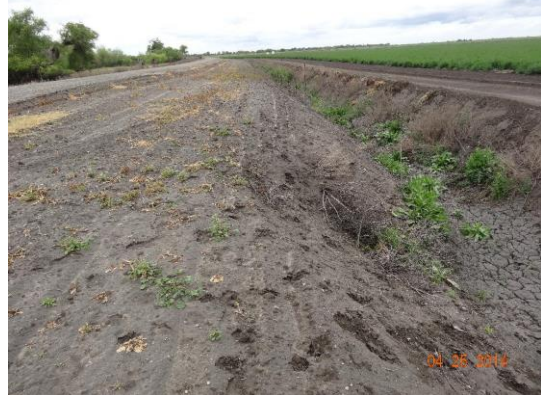
Photo 2 of 2 : UCIP_SP_2024_77848_65698.jpg

Crossing not found on landward side. No signs on canal located on landward side.

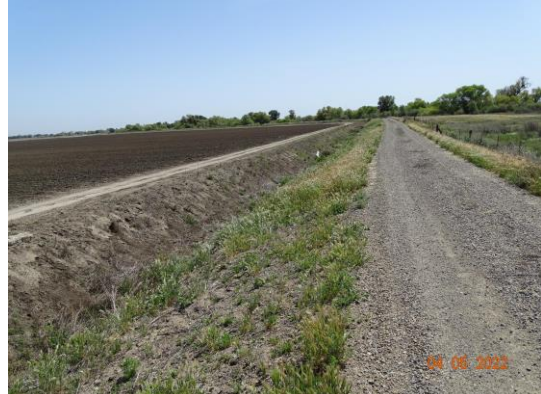
Photo 1 of 1 : SP_2024_NA0010_118_22_20240212_00004.jpg

LM Start	22.06	Rating **	A/W	Issue No.	22
LM End	22.52	Issue Type +	En	Location *	LS
Category	Earthen Levee			GPS Latitude/Longitude	
				Start	End
Item	Encroachments			37.172074°	37.166906°
				-120.754628°	-120.749962°
DWR ID	DWR_NA0010_01_s_2020_22				
Comment Code					
DT : Ditch					
Inspector Comment					
Ditch is permitted under CVFPB permit 3332

Looking upstream at irrigation at landside toe. (Spring 2022)

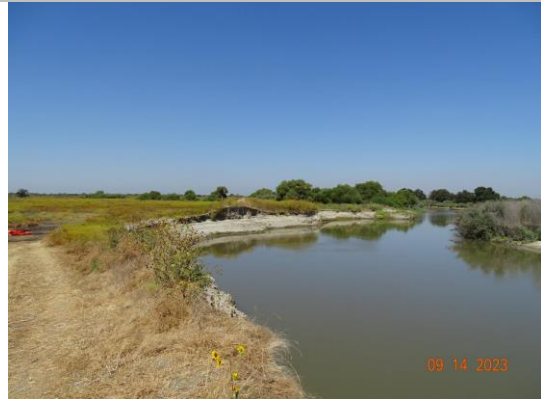
Photo 1 of 1 : SP_2024_NA0010_119_25_20240212_00003.jpg

LM Start	0.71	Rating **	A/W	Issue No.	25
LM End	0.76	Issue Type +	Ob	Location *	WS
Category	Earthen Levee			GPS Latitude/Longitude	
				Start	End
Item	Erosion / Bank Caving			37.287517°	37.286800°
				-120.874583°	-120.874103°
DWR ID	DWR_NA0010_02A_f_2023_25				
Comment Code					
E2 : Schedule repair of erosion site prior to the next inspection.					
Inspector Comment					
Site ID: NA0010U02ARM129.22					
08/03/2022: From 2021 to present, no significant changes were observed during the annual survey. The length was extended to 300 ft.					
08/20/2020: This site was discovered during the DWR Spring 2012 Levee Inspections. A 250-ft long levee section has completely eroded away and no longer provides adequate flood protection. Note: Unit 2A is in the process of being turned over to State Parks.

View of erosion through the levee crown looking downstream. (Fall 2023)

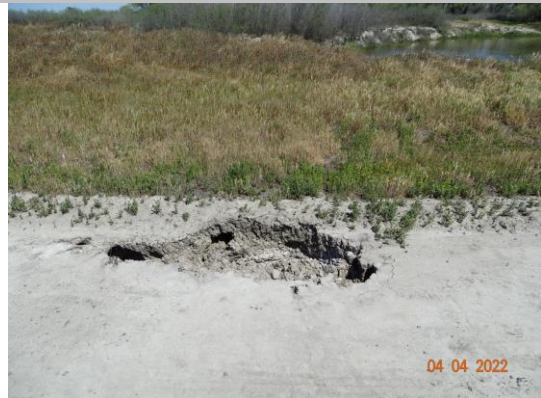
Photo 1 of 1 : SP_2024_NA0010_119_26_20240212_00004.jpg

LM Start	0.74	Rating **	A/W	Issue No.	26
LM End	0.74	Issue Type +	Ma	Location *	LS
Category	Earthen Levee			GPS Latitude/Longitude	
				Start	End
Item	Animal Control			37.287094°	37.287094°
				-120.874422°	-120.874422°
DWR ID	DWR_NA0010_02A_s_2022_26				
Comment Code					
A3 : No rodents visible, but rodent burrows visible; need to backfill and compact or grout burrows.					
Inspector Comment					
Rodent burrow caved in along the landside toe. The toe is used in this section to bypass the erosion through the levee crown.

Ground on the landside toe collapsed from rodent activity. (Spring 2022)

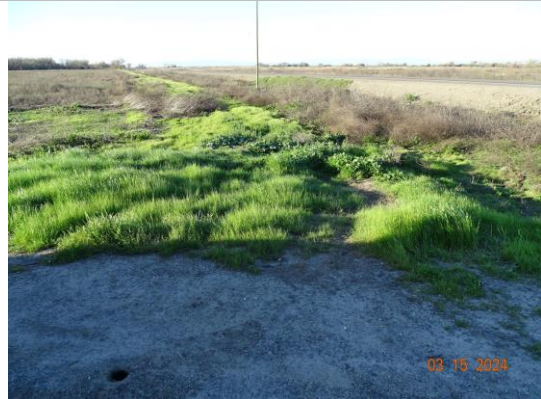
Photo 1 of 1 : SP_2024_NA0010_119_2_20240326_00033.jpg

LM Start	2.32	Rating **	M	Issue No.	2
LM End	2.32	Issue Type +	En	Location *	LS
Category	Earthen Levee			GPS Latitude/Longitude	
				Start	End
Item	Encroachments			37.291433°	37.291433°
				-120.850917°	-120.850917°
DWR ID	DWR_NA0010_02A_s_2012_2				
Comment Code					
RA : Ramp					
Inspector Comment					
Unauthorized ramps are located on the landside and waterside slopes.

View of unauthorized ramp on the landside slope. (Spring 2024)

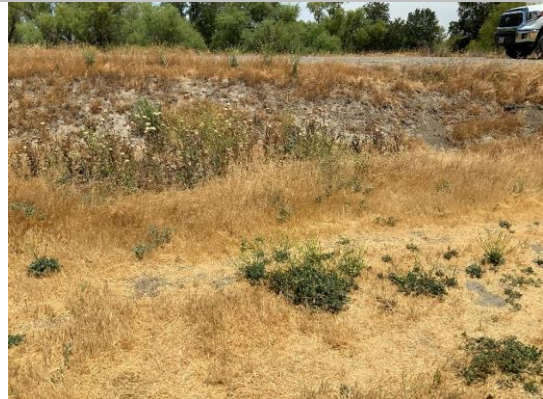
Photo 3 of 3 : UCIP_SP_2024_70942_100121.jpg

LS view: Slope from toe.

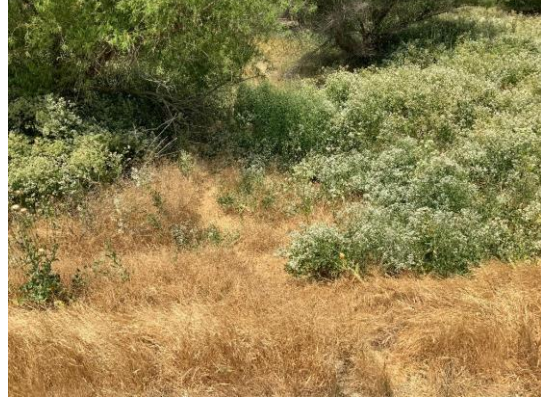
Photo 1 of 1 : UCIP_SP_2024_70944_100142.jpg

Comment Code					
Inspector Comment					
DS_ID:19665 FS_ID:70944 EP_NO: N/A Repair Type: Non-Urgent EVAL Issue: 11, Maintenance Compliance Issue Crossing Status: Found UCIP Comments: 06/7/2021 The record remains Non-Urgent. Dense vegetation limited view and inspection of LS pipe inlet. Recommend removal of LS vegetation. No permit was found authorizing this encroachment. CVFPB will need to review crossing to determine owner. The UCIP inspection was completed with GEI staff, P. Espinoza. (H. Dunn – GEI) 05/01/2014 Dense vegetation limits the inspector's visibility to identify signs of pipe failure (leaks) along the slope. Recommend removing vegetation along pipe alignment to conduct proper inspection of structure. (O. Magana - DWR UCIP) FIELD_STRUCT_DESC: 24-inch corrugated metal gravity drainage pipe (CMP) through the levee, 12.4 feet below the crown. Flap gate on the waterside (WS) end. Brass cap No. 130 bench mark (BM) on the headwall on the landside (LS). [Additional Reference(s): DWR Levee Log, 2002, (HLM 3.31). USACE San Joaquin O&M Manual, Unit No. 601, Part No. 1, 1967, Amended in 1978, Revised 20 June 1985, (HLM 3.29)]. FS Date: 6/7/2021

LS view: Toe from crown, pipe end not visible.

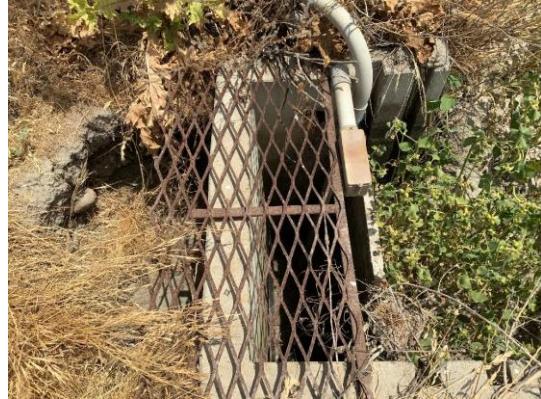
Photo 1 of 1 : UCIP_SP_2024_83301_100143.jpg

Comment Code					
Inspector Comment					
DS_ID:19666 FS_ID:83301 EP_NO: N/A Repair Type: Urgent EVAL Issue: 1, Pipe Integrity Crossing Status: Found UCIP Comments: 12/14/2022 Record updated from Non-Urgent to Urgent. DMP internal video inspection has found pipe integrity issues. LOF of crossing is between 5 and 6. Crossing will be monitored until funding becomes available to address the issues. (O. Yakimov - DWR UCIP) 06/7/2021 The record remains Non-Urgent. LS has boards blocking the open pipe inlet but there is significant sediment and vegetation on the other side of the boards, recommend cleaning around. No permit was found authorizing this encroachment. CVFPB will need to review crossing to determine owner. The UCIP inspection was completed with GEI staff, P. Espinoza. (H. Dunn – GEI) 05/01/2014 Dense vegetation limits the inspector's visibility to identify signs of pipe failure (leaks) along the slope. Recommend removing vegetation along pipe alignment to conduct proper inspection of structure. (O. Magana - DWR UCIP) FIELD_STRUCT_DESC: 24-inch corrugated metal gravity drainage pipe (CMP) through the levee, 10.0 feet below the crown. Flap gate on the waterside (WS) end. Brass cap No. 130 bench mark (BM) on the headwall on the landside (LS). [Additional Reference(s): DWR Levee Log, 2002, (HLM 3.63). USACE San Joaquin O&M Manual, Unit No. 601, Part No. 1, 1967, Amended in 1978, Revised 20 June 1985, (HLM 3.62)]. FS Date: 6/7/2021 1:46:07 PM

LS view: Close up of pipe inlet and headwall. Sediment behind boards blocking pipe inlet.

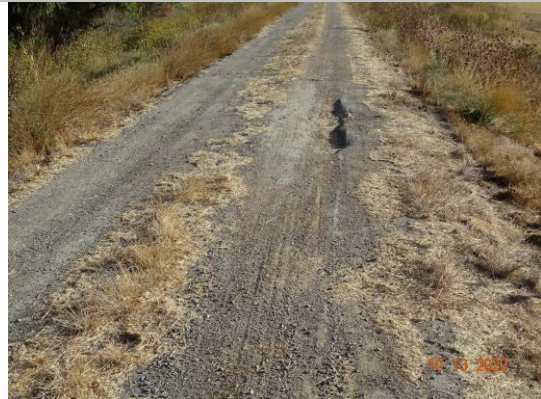
Photo 1 of 1 : SP_2024_NA0010_119_23_20240212_00002.jpg

LM Start	3.69	Rating **	M	Issue No.	23
LM End	3.69	Issue Type +	Ma	Location *	CR
Category	Earthen Levee			GPS Latitude/Longitude	
				Start	End
Item	Crown Surface / Depressions / Rutting			37.278949 °	37.278949 °
				-120.838776 °	-120.838776 °
DWR ID	DWR_NA0010_02A_f_2020_23				
Comment Code					
C2 : Repair depressions or ruts in the crown or slope.					
Inspector Comment

Rutting along the levee crown. (Fall 2023)

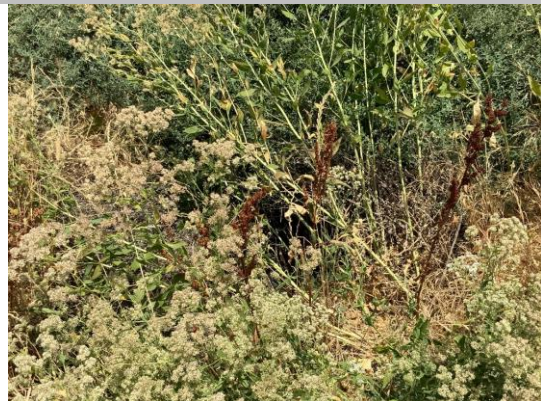
Photo 1 of 1 : UCIP_SP_2024_70946_100157.jpg

Comment Code						
Inspector Comment						
DS_ID:19667 FS_ID:70946 EP_NO: N/A Repair Type: Non-Urgent EVAL Issue: 11, Maintenance Compliance Issue Crossing Status: Found UCIP Comments: 06/7/2021 The record remains Non-Urgent. Dense vegetation around LS pipe inlet, recommend removal. No permit was found authorizing this encroachment. CVFPB will need to review crossing to determine owner. The UCIP inspection was completed with GEI staff, P. Espinoza. (H. Dunn – GEI) 05/01/2014 Signs of erosion or sink hole present on landward toe--Need to contact owner. Dense vegetation limits the inspector's visibility to identify signs of pipe failure (leaks) along the slope. Recommend removing vegetation along pipe alignment to conduct proper inspection of structure. (O. Magana - DWR UCIP) FIELD_STRUCT_DESC: 24-inch corrugated metal gravity drainage pipe (CMP) through the levee, 8.6 feet below the crown. Flap gate on the waterside (WS) end. Brass cap No. 130 bench mark (BM) on the headwall on the landside (LS). [Additional Reference(s): DWR Levee Log, 2002, (HLM 3.96). USACE San Joaquin O&M Manual, Unit No. 601, Part No. 1, 1967, Amended in 1978, Revised 20 June 1985, (HLM 3.95)]. FS Date: 6/7/2021

LS view: Close up of pipe inlet at toe covered in vegetation.

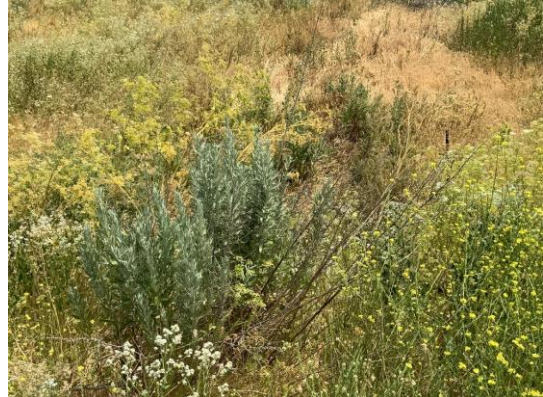
Photo 1 of 1 : UCIP_SP_2024_77860_100161.jpg

Comment Code						
Inspector Comment						
DS_ID:19668 FS_ID:77860 EP_NO: N/A Repair Type: Urgent EVAL Issue: 1, Pipe Integrity Crossing Status: Found UCIP Comments: 12/14/2022 Record updated from Non-Urgent to Urgent. DMP internal video inspection has found pipe integrity issues. LOF of crossing is between 5 and 6. Crossing will be monitored until funding becomes available to address the issues. (O.Yakimov - DWR UCIP) 06/7/2021 The record remains Non-Urgent. Limited inspection on WS due to dense vegetation, flapgate not visible, recommend clearing away. Limited insepction on LS due to canal limiting access to inlet. No permit was found authorizing this encroachment. CVFPB will need to review crossing to determine owner. The UCIP inspection was completed with GEI staff, P. Espinoza. (H. Dunn – GEI) 05/01/2014 Dense vegetation limits the inspector's visibility to identify signs of pipe failure (leaks) along the slope. Recommend removing vegetation along pipe alignment to conduct proper inspection of structure. (O. Magana - DWR UCIP) FIELD_STRUCT_DESC: 24-inch corrugated metal gravity drainage pipe (CMP) through the levee, 8.0 feet below the crown. Flap gate on the waterside (WS) end. Brass cap No. 125 bench mark (BM) on the headwall on the landside (LS). [Additional Reference(s): DWR Levee Log, 2002, (HLM 5.45). USACE San Joaquin O&M Manual, Unit No. 601, Part No. 1, 1967, Amended in 1978, Revised 20 June 1985, (HLM 5.43)]. FS Date: 6/7/2021 1:46:28 PM

WS view: Flapgate completely covered by vegetation at toe.

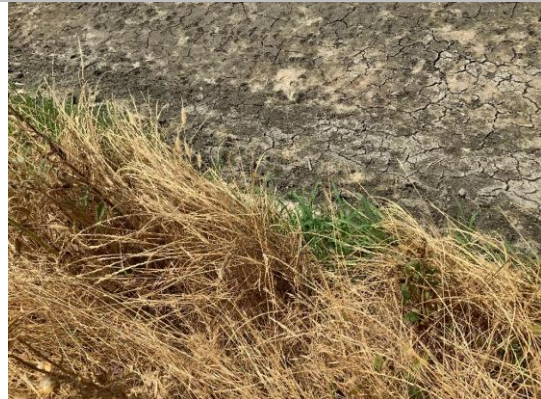
Photo 1 of 1 : UCIP_SP_2024_77861_100170.jpg

Comment Code						
Inspector Comment						
DS_ID:19669 FS_ID:77861 EP_NO: N/A Repair Type: Urgent EVAL Issue: 1, Pipe Integrity Crossing Status: Found UCIP Comments: 12/14/2022 Record updated from Non-Urgent to Urgent. DMP internal video inspection has found pipe integrity issues. LOF of crossing is between 5 and 6. Crossing will be monitored until funding becomes available to address the issues. (O.Yakimov - DWR UCIP) 06/7/2021 The record remains Non-Urgent. LS pipe inlet completely buried under sediment, recommend clearing out. No permit was found authorizing this encroachment. CVFPB will need to review crossing to determine owner. The UCIP inspection was completed with GEI staff, P. Espinoza. (H. Dunn – GEI) 05/01/2014 Dense vegetation limits the inspector's visibility to identify signs of pipe failure (leaks) along the slope. Recommend removing vegetation along pipe alignment to conduct proper inspection of structure. (O. Magana - DWR UCIP) FIELD_STRUCT_DESC: 24-inch corrugated metal gravity drainage pipe (CMP) through the levee, 7.7 feet below the crown. Flap gate on the waterside (WS) end. Brass cap No. 125 bench mark (BM) on the headwall on the landside (LS). [Additional Reference(s): DWR Levee Log, 2002, (HLM 6.06). USACE San Joaquin O&M Manual, Unit No. 601, Part No. 1, 1967, Amended in 1978, Revised 20 June 1985, (HLM 6.06)]. FS Date: 6/7/2021 1:46:46 PM

LS view: Headwall barely visible at toe, buried under sediment.

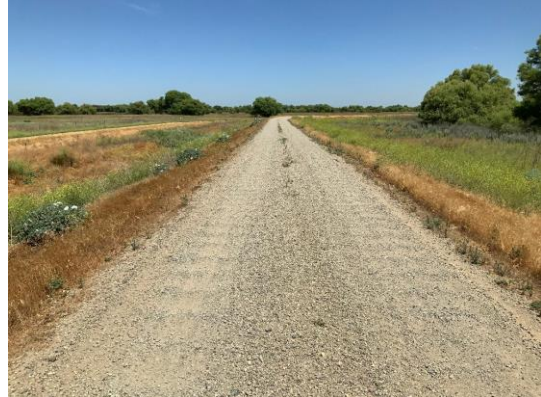
Photo 1 of 3 : UCIP_SP_2024_77862_100173.jpg

Comment Code						
Inspector Comment						
DS_ID:19670 FS_ID:77862 EP_NO: N/A Repair Type: Urgent EVAL Issue: 1, Pipe Integrity Crossing Status: Found UCIP Comments: 12/14/2022 Record updated from Non-Urgent to Urgent. DMP internal video inspection has found pipe integrity issues. LOF of crossing is between 5 and 6. Crossing will be monitored until funding becomes available to address the issues. (O.Yakimov - DWR UCIP) 06/7/2021 The record remains Non-Urgent. Limited inspection on LS due to canal and inability to access. No permit was found authorizing this encroachment. CVFPB will need to review crossing to determine owner. The UCIP inspection was completed with GEI staff, P. Espinoza. (H. Dunn – GEI) 05/01/2014 Dense vegetation limits the inspector's visibility to identify signs of pipe failure (leaks) along the slope. Recommend removing vegetation along pipe alignment to conduct proper inspection of structure. (O. Magana - DWR UCIP) FIELD_STRUCT_DESC: 24-inch corrugated metal gravity drainage pipe (CMP) through the levee, 7.7 feet below the crown. Flap gate on the waterside (WS) end. Brass cap No. 125 bench mark (BM) on the headwall on the landside (LS). [Additional Reference(s): DWR Levee Log, 2002, (HLM 6.50). USACE San Joaquin O&M Manual, Unit No. 601, Part No. 1, 1967, Amended in 1978, Revised 20 June 1985, (HLM 6.50)]. FS Date: 6/7/2021 1:47:06 PM

Levee crown looking downstream.

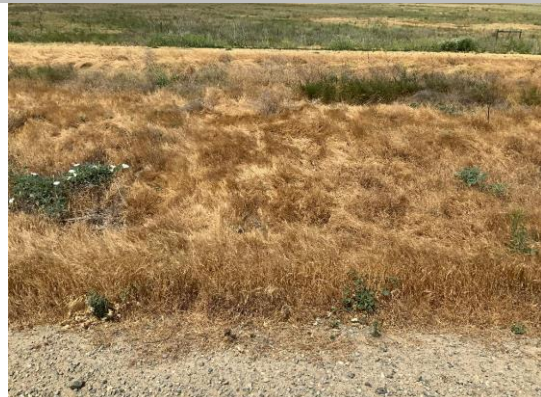
Photo 2 of 3 : UCIP_SP_2024_77862_100177.jpg

LS view: Toe from crown.

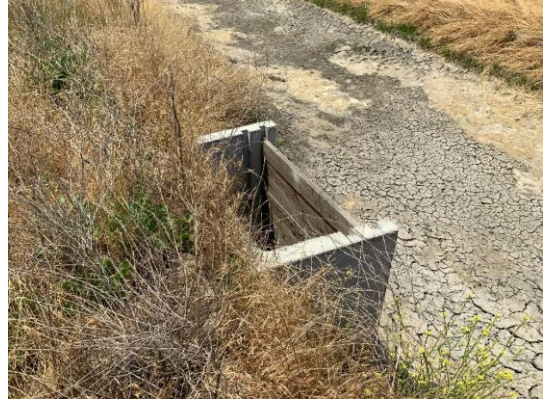
Photo 3 of 3 : UCIP_SP_2024_77862_100171.jpg

LS view: Close up of concrete box and pipe inlet.

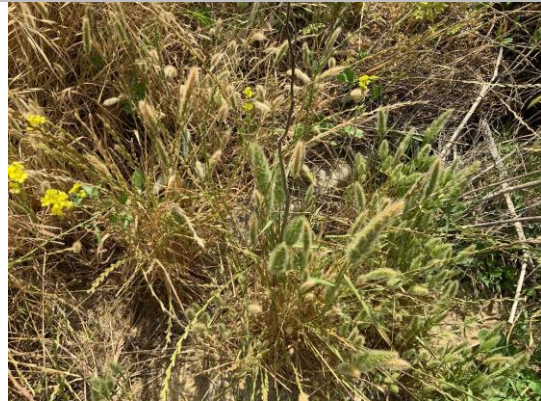
Photo 1 of 2 : UCIP_SP_2024_70950_100183.jpg

Comment Code						
Inspector Comment						
DS_ID:19671 FS_ID:70950 EP_NO: N/A Repair Type: Non-Urgent EVAL Issue: 11, Maintenance Compliance Issue Crossing Status: Found UCIP Comments: 06/7/2021 The record remains Non-Urgent. Dense vegetation on WS limited inspection. LS pipe inlet is completely buried under sediment, recommend cleaning out. No permit was found authorizing this encroachment. CVFPB will need to review crossing to determine owner. The UCIP inspection was completed with GEI staff, P. Espinoza. (H. Dunn – GEI) 05/01/2014 Dense vegetation limits the inspector's visibility to identify signs of pipe failure (leaks) along the slope. Recommend removing vegetation along pipe alignment to conduct proper inspection of structure. Pipe extension visible on landward side--need to contact owner for additional information about extension/modification. (O. Magana - DWR UCIP) FIELD_STRUCT_DESC: 24-inch corrugated metal gravity drainage pipe (CMP) through the levee, 12.6 feet below the crown. Flap gate on the waterside (WS) end. Brass cap No. 125 bench mark (BM) on the headwall on the landside (LS). [Additional Reference(s): DWR Levee Log, 2002, (HLM 7.06). USACE San Joaquin O&M Manual, Unit No. 601, Part No. 1, 1967, Amended in 1978, Revised 20 June 1985, (HLM 7.05)]. FS Date: 6/7/2021

LS view: Headwall and inlet buried at toe.

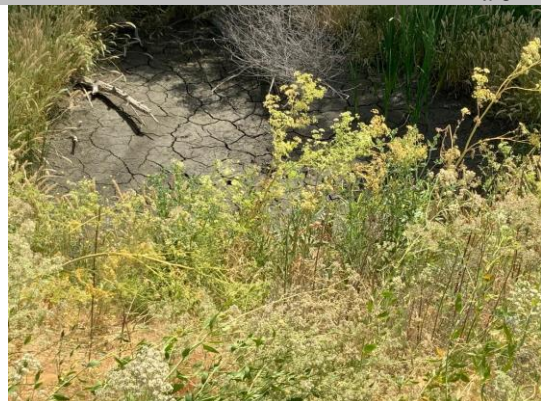
Photo 2 of 2 : UCIP_SP_2024_70950_100178.jpg

WS view: Flapgate barely visible at toe from slope.

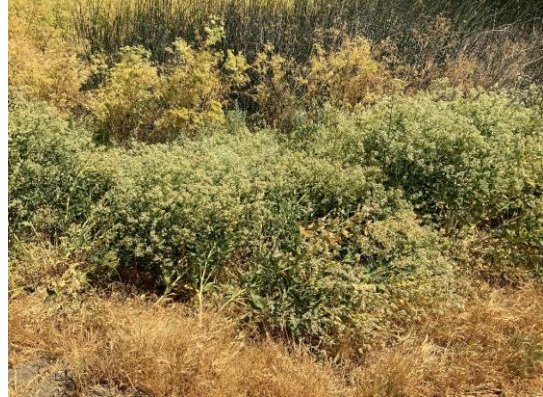
Photo 2 of 2 : UCIP_SP_2024_77863_100188.jpg

WS view: Toe from crown, flapgate covered in vegetation but just visible.

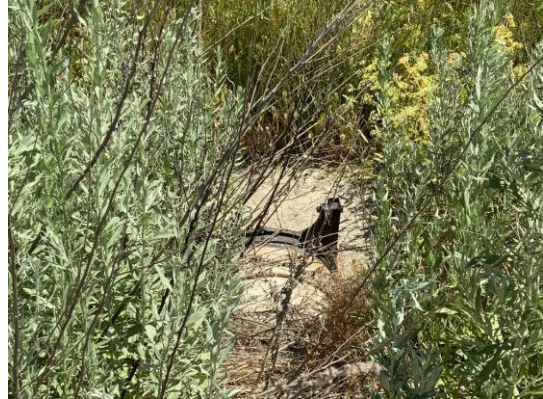
Photo 2 of 2 : UCIP_SP_2024_83302_100046.jpg

WS view: Flapgate visible at toe.

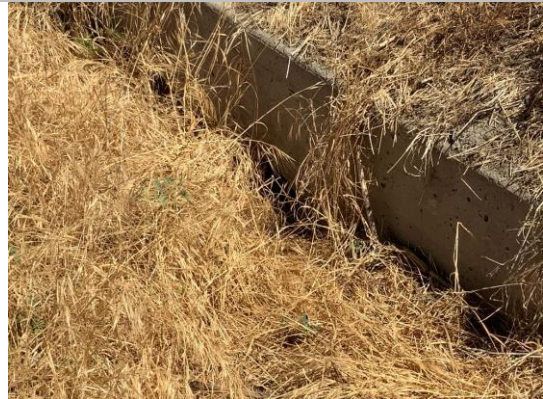
Photo 1 of 2 : UCIP_SP_2024_70954_100343.jpg

DS_ID:19675
 FS_ID:70954
 EP_NO: N/A
 Repair Type: Non-Urgent
 EVAL Issue: 11, Maintenance Compliance Issue
 Crossing Status: Found
 UCIP Comments: 06/7/2021 The record remains Non-Urgent. LS pipe inlet completely buried in dense vegetation, only top of headwall visible. Dense vegetation above WS flapgate. Limited inspection of pipe ends, recommend vegetation removal on both sides. No permit was found authorizing this encroachment. CVFPB will need to review crossing to determine owner. The UCIP inspection was completed with GEI staff, P. Espinoza. (H. Dunn – GEI) 05/14/2014 Dense vegetation on landward toe. Also dense vegetation limits the inspector's visibility to identify signs of pipe failure (leaks) along waterward slope. Recommend removing vegetation along pipe alignment toe to conduct proper inspection of structure. Sediment buildup in pipe--recommend clearing. (O. Magana - DWR UCIP)
 FIELD_STRUCT_DESC: 24-inch corrugated metal gravity drainage pipe (CMP) through the levee, 9.4 feet below the crown. Flap gate on the waterside (WS) end. Brass cap No. 120 bench mark (BM) on the headwall on the landside (LS). [Additional Reference(s): DWR Levee Log, 2002, (HLM 8.49). USACE San Joaquin O&M Manual, Unit No. 601, Part No. 1, 1967, Amended in 1978, Revised 20 June 1985, (HLM 8.48)].

LS view: Close up of pipe inlet, covered in vegetation.

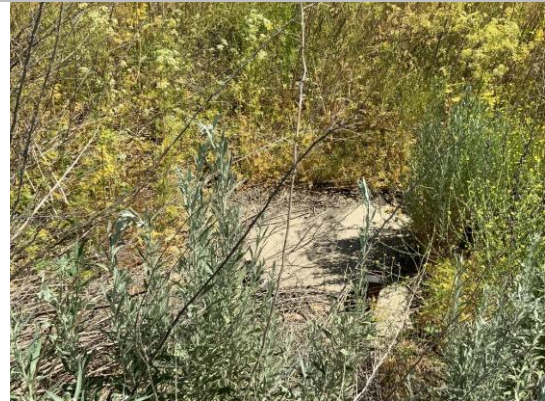
Photo 2 of 2 : UCIP_SP_2024_70954_100338.jpg

WS view: Top of flapgate visible at toe.

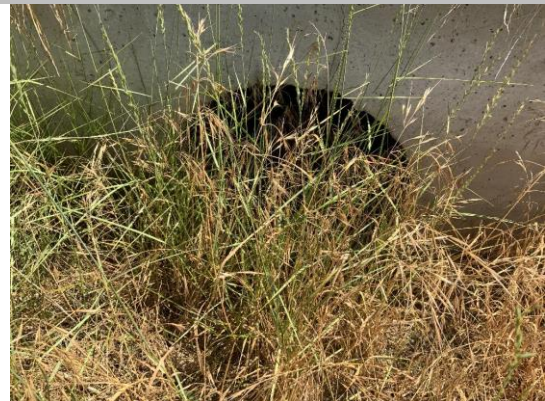
Photo 1 of 1 : UCIP_SP_2024_70955_100350.jpg

DS_ID:19676
FS_ID:70955
EP_NO: N/A
Repair Type: Non-Urgent
EVAL Issue: 11, Maintenance Compliance Issue
Crossing Status: Found
UCIP Comments: 06/7/2021 The record remains Non-Urgent. DWR DMP internal inspection has not found pipe integrity issues. LOF of crossing is less or equal to 4.0. Recommend next video inspection in 5 years. Dense vegetation around LS pipe end, recommend removal. No permit was found authorizing this encroachment. CVFPB will need to review crossing to determine owner. The UCIP inspection was completed with GEI staff, P. Espinoza. (H. Dunn – GEI) 05/14/2014 Dense vegetation limits the inspector's visibility to identify signs of pipe failure (leaks) along the slope. Recommend removing vegetation along pipe alignment to conduct proper inspection of structure. Burrow activity presen on waterward slope. (O. Magana - DWR UCIP)
FIELD_STRUCT_DESC: 24-inch corrugated metal gravity drainage pipe (CMP) through the levee, 8.8 feet below the crown. Flap gate on the waterside (WS) end. Brass cap No. 120 bench mark (BM) on the headwall on the landside (LS). [Additional Reference(s): DWR Levee Log, 2002, (HLM 8.88). USACE San Joaquin O&M Manual, Unit No. 601, Part No. 1, 1967, Amended in 1978, Revised 20 June 1985, (recorded as HLM 9.86, should be HLM 8.86)].

LS view: Close up of pipe inlet at toe.

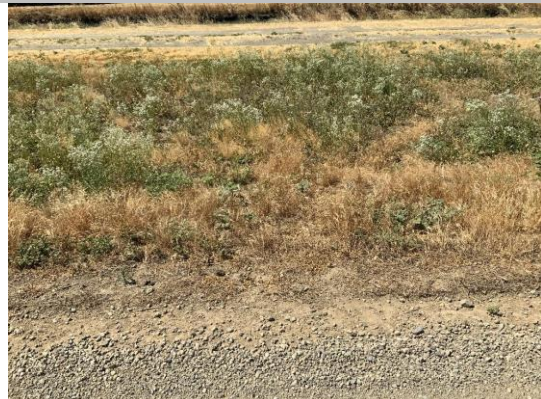
Photo 2 of 3 : UCIP_SP_2024_83303_100354.jpg

LS view: Toe from crown.

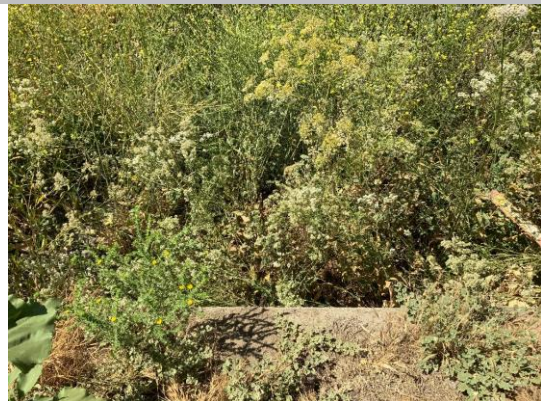
Photo 1 of 1 : UCIP_SP_2024_70957_100363.jpg

DS_ID:19678
FS_ID:70957
EP_NO: N/A
Repair Type: Non-Urgent
EVAL Issue: 11, Maintenance Compliance Issue
Crossing Status: Found
UCIP Comments: 06/7/2021 The record remains Non-Urgent. DWR DMP internal inspection has not found pipe integrity issues. LOF of crossing is less or equal to 4.0. Recommend next video inspection in 5 years. Dense vegetation over LS pipe inlet limited inspection, recommend removal. No permit was found authorizing this encroachment. CVFPB will need to review crossing to determine owner. The UCIP inspection was completed with GEI staff, P. Espinoza. (H. Dunn – GEI) 05/14/2014 Dense vegetation limits the inspector's visibility to identify signs of pipe failure (leaks) along the slope. Recommend removing vegetation along pipe alignment to conduct proper inspection of structure. (O. Magana - DWR UCIP)
FIELD_STRUCT_DESC: 24-inch corrugated metal gravity drainage pipe (CMP) through the levee, 8.0 feet below the crown. Flap gate on the waterside (WS) end. Brass cap No. 120 bench mark (BM) on the headwall on the landside (LS). [Additional Reference(s): DWR Levee Log, 2002, (HLM 9.21). USACE San Joaquin O&M Manual, Unit No. 601, Part No. 1, 1967, Amended in 1978, Revised 20 June 1985, (HLM 9.20)].

LS view: Top of headwall visible, pipe inlet covered with dense vegetation.

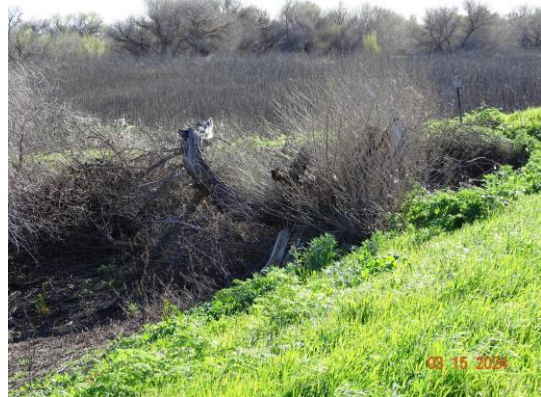
Photo 1 of 1 : SP_2024_NA0010_120_15_20240326_00027.jpg

LM Start	9.60	Rating **	M	Issue No.	15
LM End	9.60	Issue Type +	Ma	Location *	WS
Category	Earthen Levee			GPS Latitude/Longitude	
				Start	End
Item	Trim / Thin Trees			37.220783°	37.220783°
				-120.785729°	-120.785729°
DWR ID	DWR_NA0010_02B_s_2024_15				
Comment Code					
T2 : Tree or limb.					
Inspector Comment					
Broken tree limbs on the waterside slope.

View of fallen limb on the waterside slope. (Spring 2024)

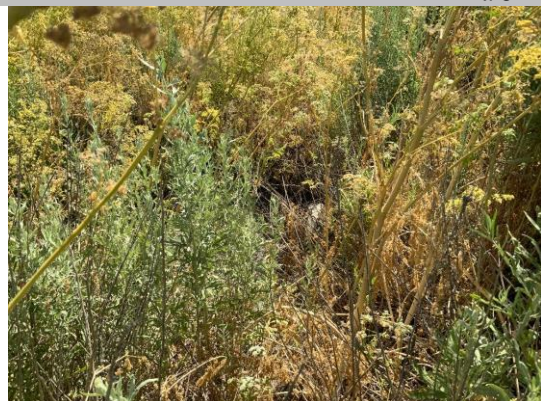
Photo 2 of 2 : UCIP_SP_2024_70960_100382.jpg

WS view: Dense vegetation covering flapgate at toe.

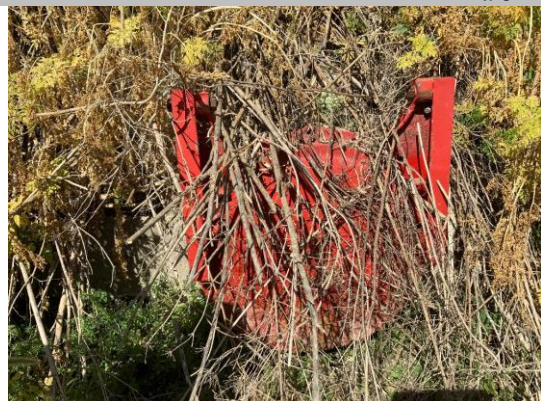
Photo 2 of 2 : UCIP_SP_2024_70962_100398.jpg

WS view: Close up of flapgate at toe.

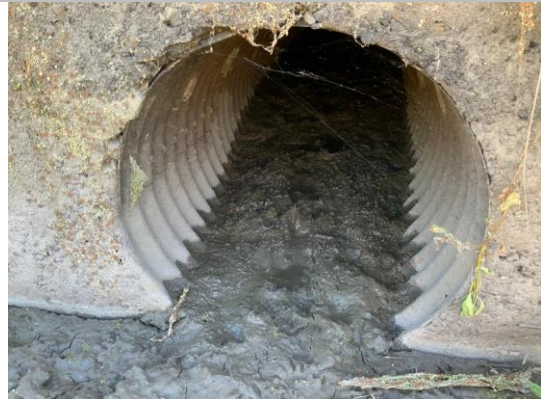
Photo 1 of 2 : UCIP_SP_2024_70963_100404.jpg

Comment Code					
Inspector Comment					
DS_ID:19663 FS_ID:70963 EP_NO: N/A Repair Type: Non-Urgent EVAL Issue: 11, Maintenance Compliance Issue Crossing Status: Found UCIP Comments: 06/7/2021 The record remains Non-Urgent. Sediment buildup inside LS pipe inlet, recommend cleaning out. Dense vegetation over WS end limited inspection, recommend removal. No permit was found authorizing this encroachment. CVFPB will need to review crossing to determine owner. The UCIP inspection was completed with GEI staff, P. Espinoza. (H. Dunn - GEI) 05/14/201 Dense vegetation limits the inspector's visibility to identify signs of pipe failure (leaks) along the slope. Recommend removing vegetation along pipe alignment to conduct proper inspection of structure. Sediment buildup in pipe-- recommend clearing. (O. Magana - DWR UCIP) FIELD_STRUCT_DESC: 24-inch corrugated metal gravity drainage pipe (CMP) through the levee, 6.5 feet below the crown. Slide gate in a pipe riser unit on the waterside (WS) slope. [Additional Reference(s): DWR Levee Log, 2002, (HLM 13.23). USACE San Joaquin O&M Manual, Unit No. 601, Part No. 1, 1967, Amended in 1978, Revised 20 June 1985, (HLM 13.22)]. FS Date: 6/7/2021

LM Start	13.18	Rating **	M	Issue No.	33 (cont)
LM End	13.18	Issue Type +	Ma	Location *

LS view: Close up of pipe inlet at toe, sediment buildup.

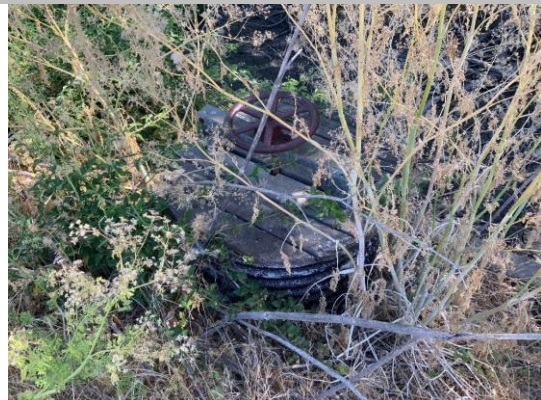
Photo 2 of 2 : UCIP_SP_2024_70963_100399.jpg

WS view: Close up of riser with slidegate on slope.

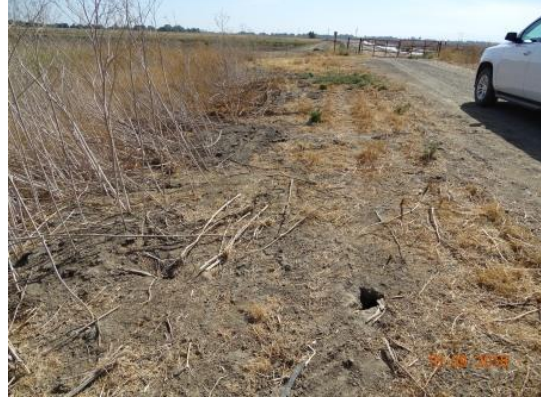
Photo 1 of 1 : SP_2024_NA0010_120_22_20240212_00004.jpg

LM Start	13.73	Rating **	A/W	Issue No.	22
LM End	13.73	Issue Type +	Ma	Location *	WS
Category	Earthen Levee			GPS Latitude/Longitude	
				Start	End
Item	Animal Control			37.172387°	37.172387°
				-120.761190°	-120.761190°
DWR ID	DWR_NA0010_02B_f_2018_22				
Comment Code					
A1 : Exterminate rodents and backfill and compact or grout burrows.					
Inspector Comment					
There are several rodent burrows observed at this location.

View of waterside slope looking upstream. (Fall 2018)

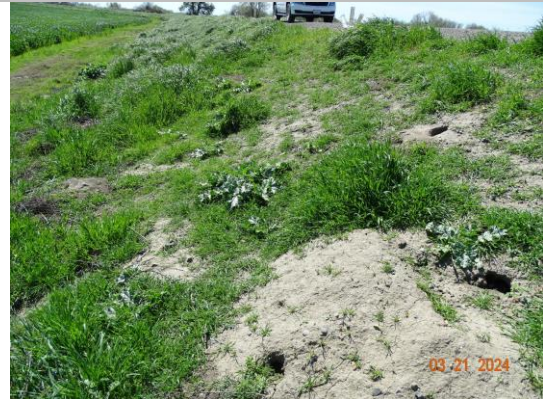
Photo 1 of 1 : SP_2024_NA0010_121_67_20240326_00017.jpg

LM Start	0.15	Rating **	M	Issue No.	67
LM End	0.19	Issue Type +	Ma	Location *	LS
Category	Earthen Levee			GPS Latitude/Longitude	
				Start	End
Item	Animal Control			37.109571°	37.109013°
				-120.587793°	-120.587799°
DWR ID	DWR_NA0010_03_s_2015_67				
Comment Code					
A3 : No rodents visible, but rodent burrows visible; need to backfill and compact or grout burrows.					
Inspector Comment					
Rodent holes are noted on the landside slope. LMA has placed bait stations in the area.

View of rodent burrows on the landside slope. (Spring 2024)

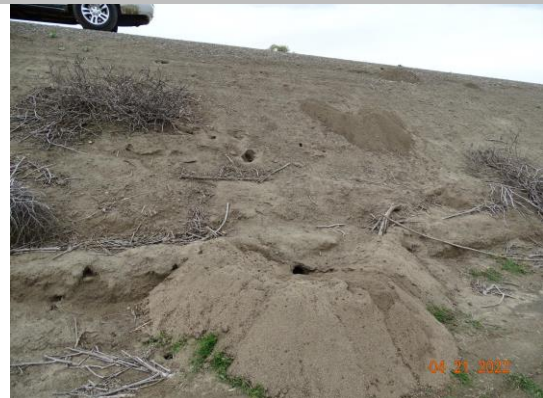
Photo 1 of 1 : SP_2024_NA0010_121_11_20240212_00004.jpg

LM Start	0.31	Rating **	U	Issue No.	11
LM End	0.31	Issue Type +	Ma	Location *	LS
Category	Earthen Levee			GPS Latitude/Longitude	
				Start	End
Item	Animal Control			37.107440°	37.107440°
				-120.587005°	-120.587005°
DWR ID	DWR_NA0010_03_s_2022_11				
Comment Code					
A3 : No rodents visible, but rodent burrows visible; need to backfill and compact or grout burrows.					
Inspector Comment					
Large amount of material displaced on the landside toe.

View of several rodent holes with large amounts of material displaced. (Spring 2022)

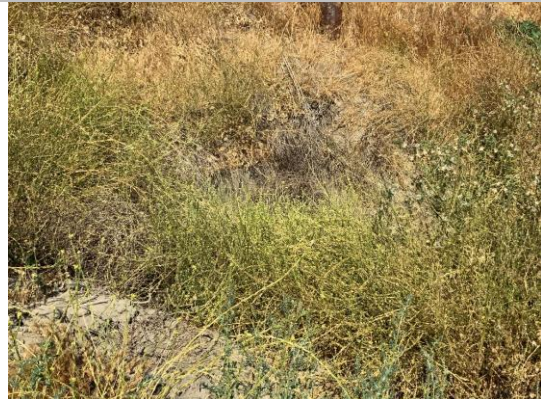
Photo 1 of 1 : UCIP_SP_2024_70965_101342.jpg

Comment Code						
Inspector Comment						
DS_ID:19691 FS_ID:70965 EP_NO: N/A Repair Type: Non-Urgent EVAL Issue: 11, Maintenance Compliance Issue Crossing Status: Found UCIP Comments: 07/12/2021 The record remains Non-Urgent. Dense vegetation over LS pipe inlet, headwall just barely visible, recommend removal. No permit was found authorizing this encroachment. CVFPB will need to review crossing to determine owner. The UCIP inspection was completed with GEI staff, P. Espinoza. (H. Dunn – GEI)						
04/17/2014 Need to contact owner. Recommend removing tall grass on landward slope and clearing sediment build up inside pipe. (O. Magana - DWR UCIP) FIELD_STRUCT_DESC: 24-inch corrugated metal gravity drainage pipe (CMP) through the levee, 11.3 feet below the crown. Flap gate on the waterside (WS) end. [Additional Reference(s): DWR Levee Log, 2002, (HLM 0.43). USACE San Joaquin O&M Manual, Unit No. 601, Part No. 1, 1967, Amended in 1978, Revised 20 June 1985, (HLM 0.43). DWR As-Built Specification No. 62-03, Sheet No. 10, 18 June 1962, (HLM 0.43)]. FS Date: 7/12/2021

LS toe: Headwall buried under vegetation.

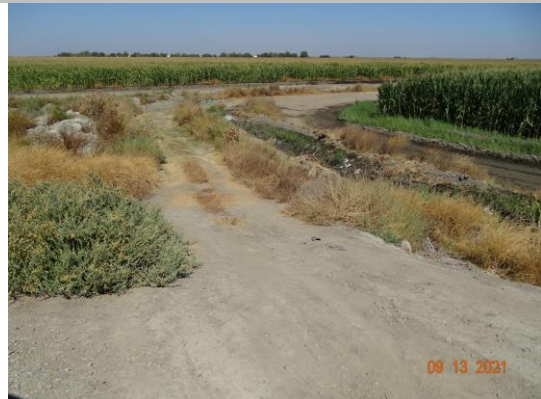
Photo 1 of 1 : SP_2024_NA0010_121_6_20240212_00002.jpg

LM Start	0.43	Rating **	M	Issue No.	6
LM End	0.43	Issue Type +	En	Location *	LS
Category	Earthen Levee			GPS Latitude/Longitude	
				Start	End
Item	Encroachments			37.106121°	37.106121°
				-120.585680°	-120.585680°
DWR ID	DWR_NA0010_03_f_2017_6				
Comment Code					
RA : Ramp					
Inspector Comment

Looking east at the landside slope. (Fall 2021)
