Flood Control Project Maintenance
Levee Inspections
LMA District Cover Sheet

Lower San Joaquin Levee District

**Flood Control Project Maintenance
Levee Inspections
Unit Cover Sheet**

Levee Inspection Report By Mile - Spring 2024

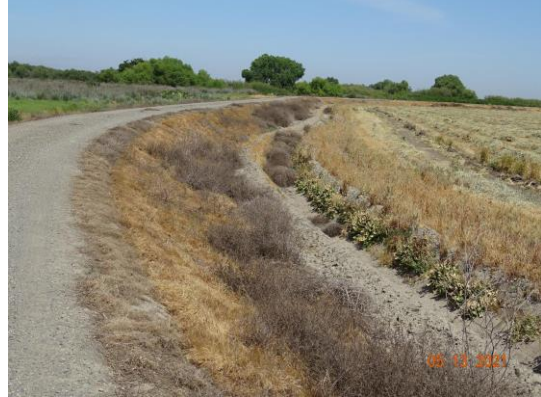
Photo 1 of 1 : SP_2024_NA0010_121_13_20240212_00006.jpg

LM Start	0.43	Rating **	A/W	Issue No.	13
LM End	2.02	Issue Type +	En	Location *	LS
Category	Earthen Levee			GPS Latitude/Longitude	
				Start	End
Item	Encroachments			37.106072°	37.089499°
				-120.585636°	-120.568041°
DWR ID	DWR_NA0010_03_s_2021_13				
Comment Code					
DT : Ditch					
Inspector Comment					
Ditch has been move approximately 10-15 off the levee toe.

View of ditch dug on the landside toe. (Spring 2021)

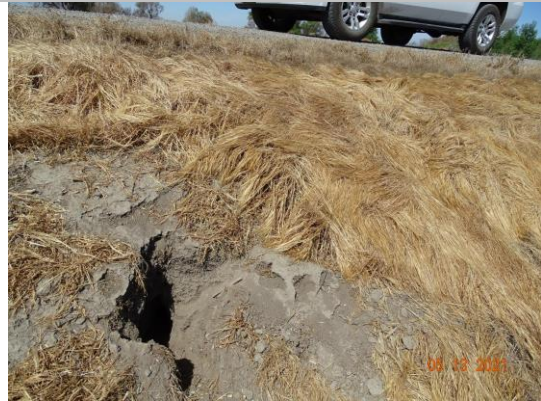
Photo 1 of 1 : SP_2024_NA0010_121_10_20240212_00003.jpg

LM Start	0.57	Rating **	A/W	Issue No.	10
LM End	0.57	Issue Type +	Ma	Location *	LS
Category	Earthen Levee			GPS Latitude/Longitude	
				Start	End
Item	Animal Control			37.104343°	37.104343°
				-120.584348°	-120.584348°
DWR ID	DWR_NA0010_03_s_2021_10				
Comment Code					
A3 : No rodents visible, but rodent burrows visible; need to backfill and compact or grout burrows.					
Inspector Comment

Several large rodent burrows observed at this location. (Spring 2021)

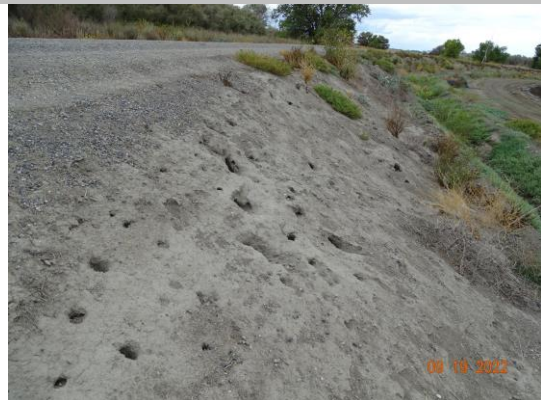
Photo 1 of 1 : SP_2024_NA0010_121_15_20240212_00007.jpg

LM Start	0.64	Rating **	M	Issue No.	15
LM End	0.67	Issue Type +	Ma	Location *	LS
Category	Earthen Levee			GPS Latitude/Longitude	
				Start	End
Item	Animal Control			37.103722°	37.103540°
				-120.583476°	-120.582863°
DWR ID	DWR_NA0010_03_s_2021_15				
Comment Code					
A1 : Exterminate rodents and backfill and compact or grout burrows.					
Inspector Comment

View of rodent holes on the landside slope. (Fall 2022)

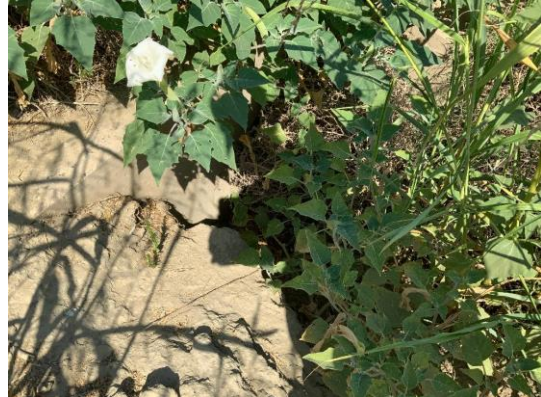
Photo 1 of 2 : UCIP_SP_2024_83306_101351.jpg

Comment Code						
Inspector Comment						
DS_ID:19692 FS_ID:83306 EP_NO: N/A Repair Type: Non-Urgent EVAL Issue: Crossing Status: Found UCIP Comments: 07/12/2021 The record has been upgraded from No Action Needed to Non-Urgent. Dense vegetation over LS pipe inlet, headwall barely visible. Minor vegetation on WS, recommend removal on both ends. No permit was found authorizing this encroachment. CVFPB will need to review crossing to determine owner. The UCIP inspection was completed with GEI staff, P. Espinoza. (H. Dunn – GEI) FIELD_STRUCT_DESC: 24-inch corrugated metal gravity drainage pipe (CMP) through the levee, 9.3 feet below the crown. Flap gate on the waterside (WS) end. [Additional Reference(s): DWR Levee Log, 2002, (HLM 0.78). USACE San Joaquin O&M Manual, Unit No. 601, Part No. 1, 1967, Amended in 1978, Revised 20 June 1985, (HLM 0.77). DWR As-Built Specification No. 62-03, Sheet No. 10, 18 June 1962, (HLM 0.77)]. FS Date: 7/12/2021

LM Start	0.76	Rating **	M	Issue No.	69 (cont)
LM End	0.76	Issue Type +	Ma	Location *

LS view: Pipe inlet and headwall covered in vegetation.

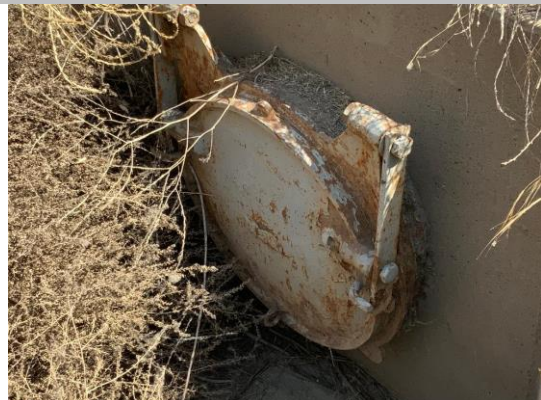
Photo 2 of 2 : UCIP_SP_2024_83306_101353.jpg

WS view: Closeup of flapgate at toe.

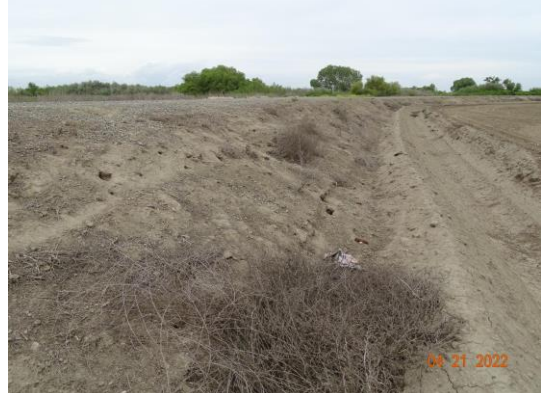
Photo 1 of 1 : SP_2024_NA0010_121_12_20240212_00005.jpg

LM Start	1.70	Rating **	M	Issue No.	12
LM End	1.78	Issue Type +	Ma	Location *	LS
Category	Earthen Levee			GPS Latitude/Longitude	
				Start	End
Item	Animal Control			37.092231°	37.091302°
				-120.572337°	-120.571632°
DWR ID	DWR_NA0010_03_f_2020_12				
Comment Code					
A1 : Exterminate rodents and backfill and compact or grout burrows.					
Inspector Comment

View of several animal holes in the landside slope. (Spring 2022)

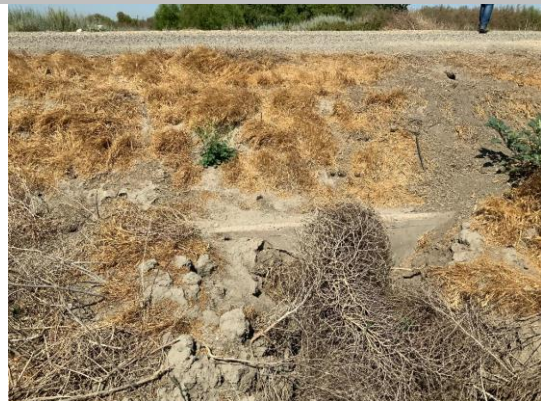
Photo 1 of 2 : UCIP_SP_2024_83307_101359.jpg

LM Start	1.71	Rating **	M	Issue No.	70
LM End	1.71	Issue Type +	Ma	Location *	
Category	Supplemental			GPS Latitude/Longitude	
				Start	End
Item	DWR UCIP LMA Responsibility			37.092079°	37.092079°
				-120.572316°	-120.572316°
DWR ID	19693

Comment Code					
Inspector Comment					
DS_ID:19693 FS_ID:83307 EP_NO: N/A Repair Type: Non-Urgent EVAL Issue: Crossing Status: Found UCIP Comments: 07/12/2021 The record remains Non-Urgent. There is dense vegetation over LS pipe inlet and WS flap gate, recommend removal. No permit was found authorizing this encroachment. CVFPB will need to review crossing to determine owner. The UCIP inspection was completed with GEI staff, P. Espinoza. (H. Dunn – GEI) 04/17/2014 Sediment buildup in pipe visible from landward side--recommend clearing. (O. Magana - DWR UCIP) FIELD_STRUCT_DESC: 24-inch corrugated metal gravity drainage pipe (CMP) through the levee, 6.8 feet below the crown. Flap gate on the waterside (WS) end. [Additional Reference(s): DWR Levee Log, 2002, (HLM 1.73). USACE San Joaquin O&M Manual, Unit No. 601, Part No. 1, 1967, Amended in 1978, Revised 20 June 1985, (HLM 1.72). DWR As-Built Specification No. 62-03, Sheet No. 11, 18 June 1962, (HLM 1.72)]. FS Date: 7/12/2021

LS view: Slope and headwall from toe.

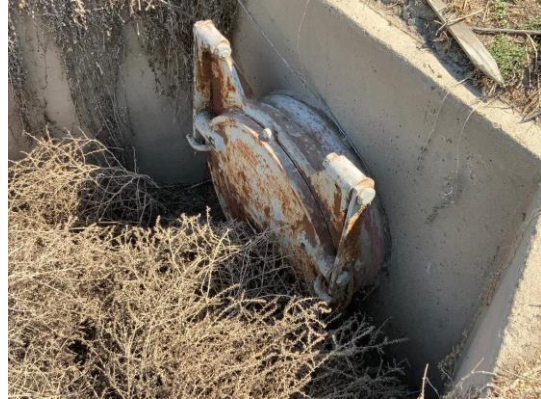
Photo 2 of 2 : UCIP_SP_2024_83307_101356.jpg

LM Start	1.71	Rating **	M	Issue No.	70 (cont)
LM End	1.71	Issue Type +	Ma	Location *	
Category	Supplemental			GPS Latitude/Longitude	
				Start	End
Item	DWR UCIP LMA Responsibility			37.092079°	37.092079°
				-120.572316°	-120.572316°
DWR ID	19693

WS view: Close up of flapgate at toe.

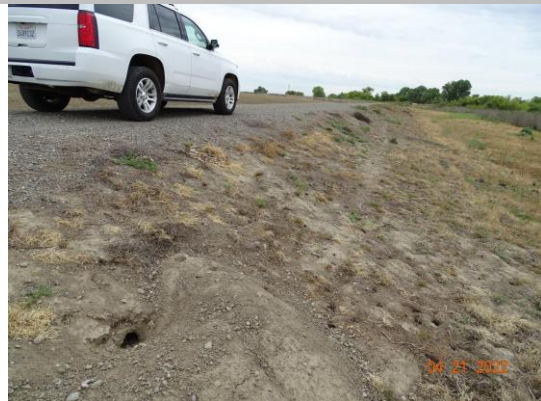
Photo 1 of 1 : SP_2024_NA0010_121_17_20240212_00008.jpg

LM Start	1.77	Rating **	A/W	Issue No.	17
LM End	1.77	Issue Type +	Ma	Location *	WS
Category	Earthen Levee			GPS Latitude/Longitude	
				Start	End
Item	Animal Control			37.091446°	37.091446°
				-120.571777°	-120.571777°
DWR ID	DWR_NA0010_03_s_2022_17				
Comment Code					
A1 : Exterminate rodents and backfill and compact or grout burrows.					
Inspector Comment

Multiple rodent burrows observed on the waterside slope. (Spring 2022)

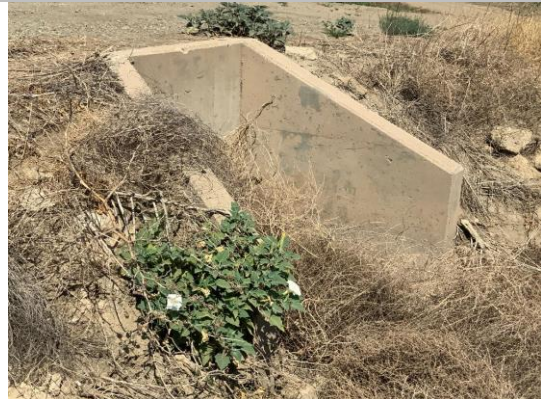
Photo 1 of 2 : UCIP_SP_2024_70968_101364.jpg

Comment Code					
Inspector Comment					
DS_ID:19694 FS_ID:70968 EP_NO: N/A Repair Type: Non-Urgent EVAL Issue: 11, Maintenance Compliance Issue Crossing Status: Found UCIP Comments: 07/12/2021 The record remains Non-Urgent. Dense vegetation over WS and LS inlet/outlet, recommend removal. As mentioned in the previous inspection, there is a 16 inch metal pipe directly opposite the WS pipe slidegate/outlet that goes just underground and out through to the channel. Recommend contacting owner for more information on these WS appurtenances. No permit was found authorizing this encroachment. CVFPB will need to review crossing to determine owner. The UCIP inspection was completed with GEI staff, P. Espinoza. (H. Dunn ? GEI) 04/17/2014 Need to contact owner--additional appurtenances found on waterward side not part of original description. Unable to determine if walkway, pump, and pipe through waterward berm is if part of original crossing. (O. Magana - DWR UCIP) FIELD_STRUCT_DESC: 36-inch corrugated metal irrigation discharge pipe (CMP) through the levee, 6.6 feet below the crown. Pump on the riverbank. Slide gate on the waterside (WS) end. [Additional Reference(s): DWR Levee Log, 2002, (HLM 2.05). USACE San Joaquin O&M Manual, Unit No. 601, Part No. 1, 1967, Amended in 1978, Revised 20 June 1985, (HLM 2.05). DWR As-Built Specification No. 62-03, Sheet No. 11, 18 June 1962, (HLM 2.05)]. FS Date: 7/12/2021

LS view: Headwall and inlet covered with tumbleweeds.

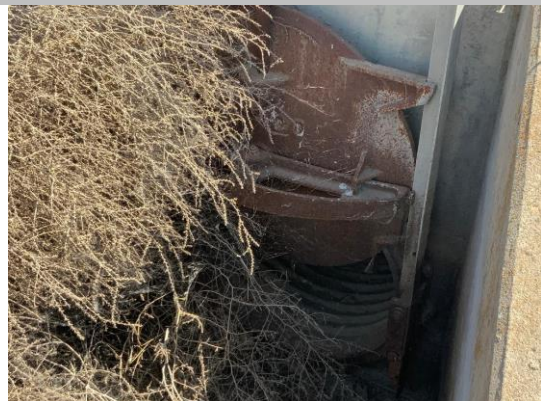
Photo 2 of 2 : UCIP_SP_2024_70968_101368.jpg

WS view: Closeup of slidegate at toe.

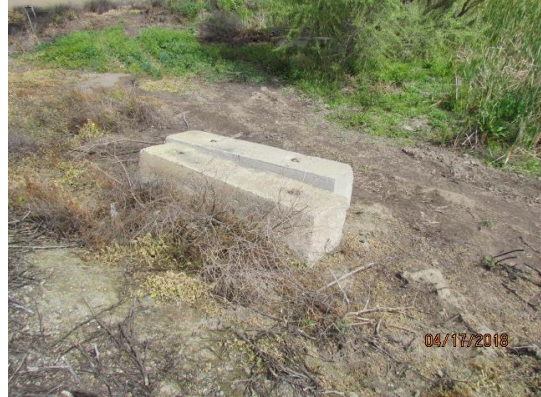
Photo 1 of 1 : SP_2024_NA0010_121_5_20240212_00001.jpg

LM Start	2.05	Rating **	U	Issue No.	5
LM End	2.05	Issue Type +	En	Location *	LS
Category	Earthen Levee			GPS Latitude/Longitude	
				Start	End
Item	Encroachments			37.089289°	37.089289°
				-120.567463°	-120.567463°
DWR ID	DWR_NA0010_03_s_ 2018_5				
Comment Code					
MA : Material					
Inspector Comment					
Two large concrete blocks are located on the landward toe.

Looking southwest at concrete blocks on landward toe. (Spring 2018)

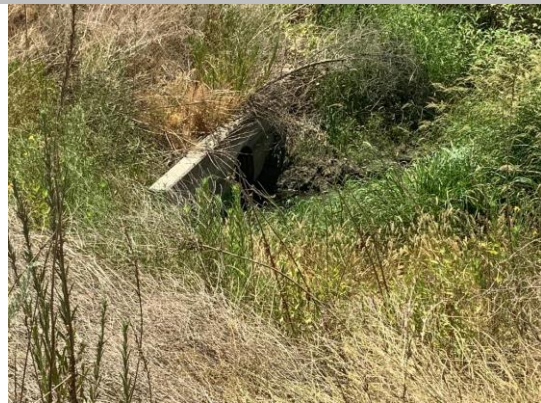
Photo 1 of 2 : UCIP_SP_2024_70974_101406.jpg

Comment Code					
Inspector Comment					
DS_ID:19695 FS_ID:70974 EP_NO: N/A Repair Type: Non-Urgent EVAL Issue: 11, Maintenance Compliance Issue Crossing Status: Found UCIP Comments: 07/12/2021 The record remains Non-Urgent. WS flapgate is underwater and covered by vegetation. LS inlet also covered by vegetation, recommend removal on both ends. No permit was found authorizing this encroachment. CVFPB will need to review crossing to determine owner. The UCIP inspection was completed with GEI staff, P. Espinoza. (H. Dunn – GEI) 04/17/2014 Sediment and debris blocking concrete headwall located on waterward side. During inspection water was flowing from landward side to waterward side. Recommend removing sediment to confirm condition of flap gate and pipe. (O. Magana - DWR UCIP) FIELD_STRUCT_DESC: 36-inch corrugated metal gravity drainage pipe (CMP) through the levee, 18.0 feet below the crown. Flap gate on the waterside (WS) end. Concrete headwall on each end. [Additional Reference(s): DWR Levee Log, 2002, (HLM 0.24). USACE San Joaquin O&M Manual, Unit No. 601, Part No. 1, 1967, Amended in 1978, Revised 20 June 1985, (HLM 0.27)]. FS Date: 7/12/2021

LS view: Pipe inlet with water in it at toe.

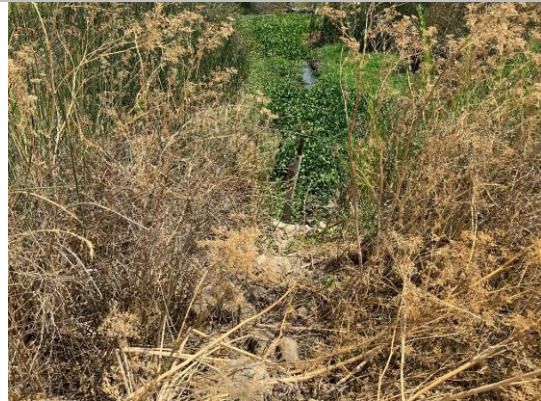
Photo 2 of 2 : UCIP_SP_2024_70974_101408.jpg

WS view: Pipe and flapgate not visible due to dense vegetation and water.

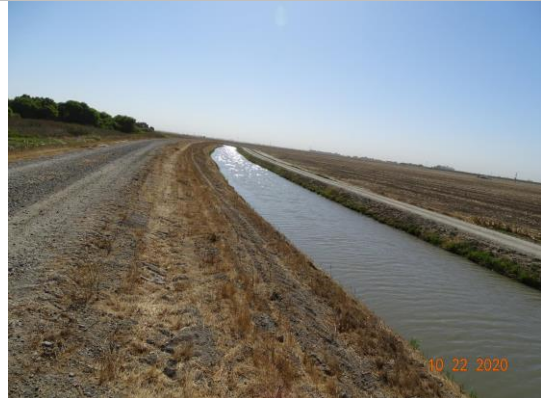
Photo 1 of 1 : SP_2024_NA0010_122_3_20240212_00001.jpg

LM Start	0.32	Rating **	A/W	Issue No.	3
LM End	1.41	Issue Type +	En	Location *	LS
Category	Earthen Levee			GPS Latitude/Longitude	
				Start	End
Item	Encroachments			37.108822°	37.097556°
				-120.590718°	-120.578130°
DWR ID	DWR_NA0010_04_s_2012_3				
Comment Code					
DT : Ditch					
Inspector Comment					
An irrigation ditch is within 10' easement. Shown on the as-built drawings.

Looking upstream at an irrigation ditch at the landside toe. (Fall 2020)

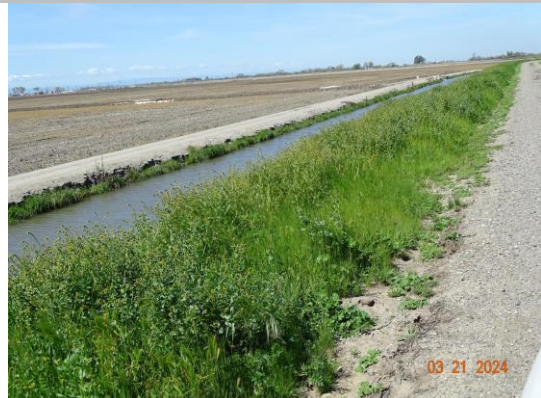
Photo 1 of 1 : SP_2024_NA0010_122_4_20240326_00005.jpg

LM Start	0.56	Rating **	M	Issue No.	4
LM End	1.41	Issue Type +	Ma	Location *	LS
Category	Earthen Levee			GPS Latitude/Longitude	
				Start	End
Item	Vegetation			37.105815°	37.097556°
				-120.588568°	-120.578130°
DWR ID	DWR_NA0010_04_s_2024_4				
Comment Code					
V1 : Control annual grass and weeds on the levee slopes and easements.					
Inspector Comment

View of vegetation on the landside slope. (Spring 2024)

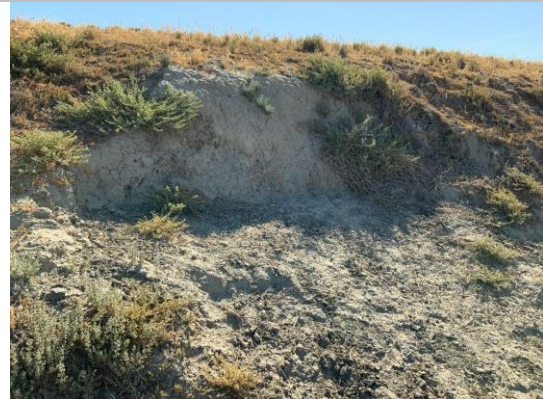
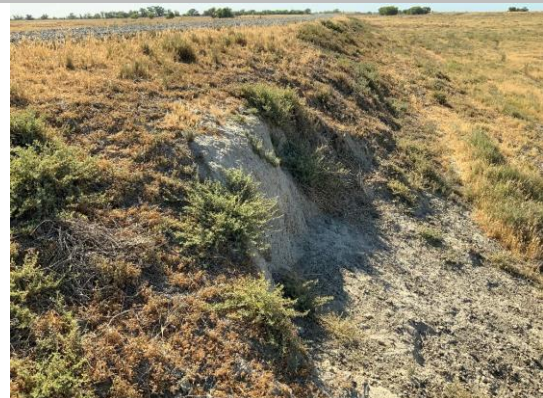
Photo 1 of 2 : UCIP_SP_2024_70983_99632.jpg

DS_ID:19756
FS_ID:70983
EP_NO: N/A
Repair Type: Non-Urgent
EVAL Issue: 6, Levee Damage or Threat for Levee Damage
Crossing Status: Found
UCIP Comments: 06/1/2021 Record remains Non-Urgent. DWR DMP internal inspection has not found pipe integrity issues. LOF of crossing is less or equal to 4.0. Recommend next video inspection in 5 years. Some soil sloughing/erosion on the WS slope. No permit was found authorizing this encroachment. CVFPB will need to review crossing to determine owner. The UCIP inspection was completed with GEI staff, P. Espinoza. (H. Dunn – GEI) 04/09/2014 Debris blocking landward headwall--recommend clearing. (W. Wylie - DWR UCIP)
FIELD_STRUCT_DESC: 24-inch corrugated metal gravity drainage pipe (CMP) through the levee, 8.6 feet below the crown. Concrete U-shaped headwall and flap gate on the waterside (WS) end. Concrete headwall on the landside (LS) end. [Additional Reference(s): DWR Levee Log, 2002, (HLM 0.07). USACE San Joaquin O&M Manual, Unit No. 601, Part No. 1, 1967, Amended in 1978, Revised 20 June 1985, (HLM 0.07)].

WS view: Sloughing on the slope from toe, 1 of 2 photos.

WS view: Side view of the sloughing on the slope, 2 of 2 photos.

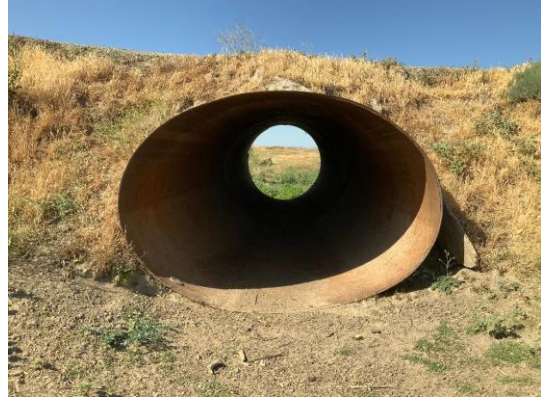
Photo 2 of 3 : UCIP_SP_2024_70984_99642.jpg

LS view: Slope and pipe inlet, top being bent down from toe.

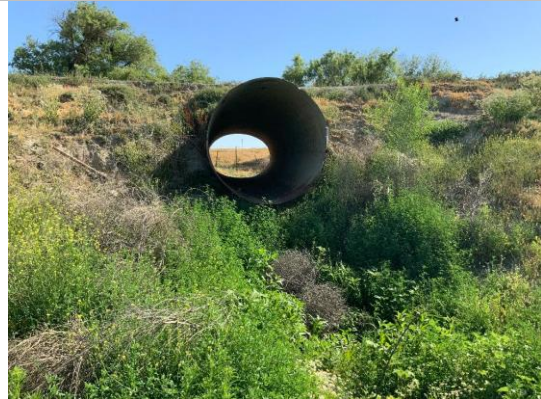
Photo 3 of 3 : UCIP_SP_2024_70984_99639.jpg

WS view: Slope and pipe outlet at toe.

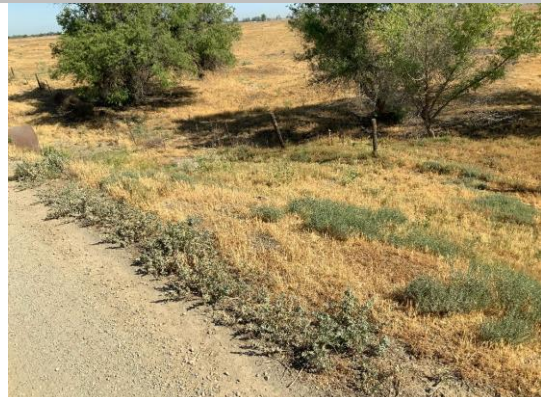
Photo 2 of 3 : UCIP_SP_2024_70985_99648.jpg

LS view: Slope and toe from crown, no pipe visible.

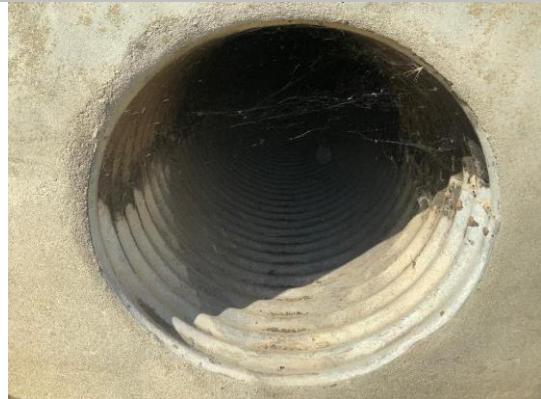
Photo 1 of 2 : UCIP_SP_2024_70986_99656.jpg

DS_ID:19757
FS_ID:70986
EP_NO: N/A
Repair Type: No Action Needed
EVAL Issue:
Crossing Status: Found
UCIP Comments: 09/18/2023 Record updated from Non-Urgent to No Action Needed. Pipe was CIPP lined. DMP internal video inspection has found none or minor pipe defects. Recommend next video inspection in 5 years. (O. Yakimov - DWR UCIP)
06/1/2021 Record remains Non-Urgent. DWR DMP internal inspection has found pipe integrity issues. LOF of crossing is greater than or equal to 4.1 and less than 5. Crossing will be monitored until funding becomes available for rehabilitation. No permit was found authorizing this encroachment. CVFPB will need to review crossing to determine owner. The UCIP inspection was completed with GEI staff, P. Espinoza. (H. Dunn – GEI) 04/09/2014 Excess debris on landward headwall--recommend clearing. (W. Wylie - DWR UCIP)
FIELD_STRUCT_DESC: 30-inch CIPP-lined corrugated metal gravity drainage pipe (CMP) through the levee, 7.5 feet below the crown. Flap gate on the waterside (WS) end. Concrete headwall on the landside (LS) end. Concrete U-shaped headwall on the WS end. [Additional Reference(s): DWR Levee Log, 2002, (HLM 0.58). USACE San Joaquin O&M Manual, Unit No. 601, Part No. 1, 1967, Amended in 1978, Revised 20 June 1985, (HLM 0.59). DWR As-Built Specification No. 63-25, Sheet No. 4, 9 May 1963, (Station -2+15)].

LS view: Close up of pipe inlet at toe.

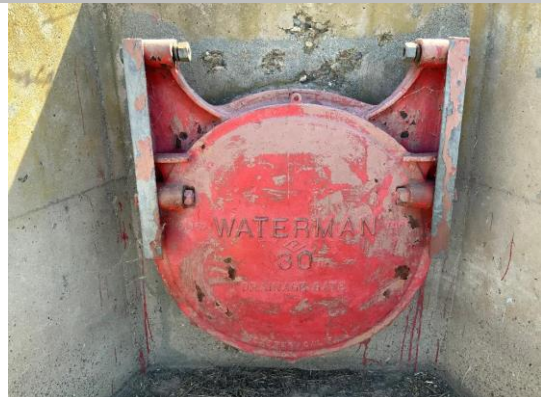
Photo 2 of 2 : UCIP_SP_2024_70986_99653.jpg

WS view: Close up of flapgate at toe.

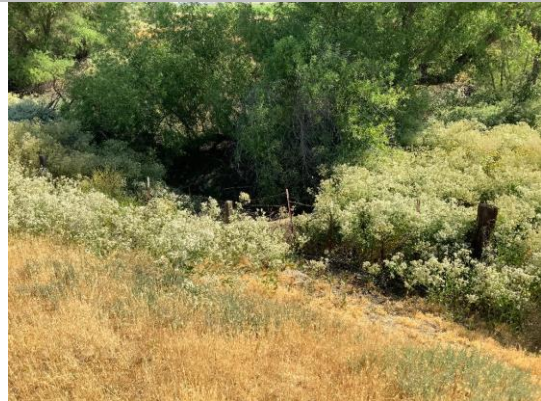
Photo 1 of 2 : UCIP_SP_2024_83309_99660.jpg

DS_ID:19758
FS_ID:83309
EP_NO: N/A
Repair Type: Non-Urgent
EVAL Issue:
Crossing Status: Found
UCIP Comments: 12/20/2022 Record updated from Urgent to Non-Urgent. Pipe has been CIPP-lined. LOF of crossing is less or equal to 4. Recommend next video inspection in 5 years. (O.Yakimov - DWR UCIP) 06/1/2021 Record has been upgraded from Non-Urgent to Urgent. DWR DMP internal inspection has found pipe integrity issues. LOF of crossing is greater than or equal to 5 and less than 6. Crossing will be monitored until funding becomes available to address the issues. No closeup inspection of LS pipe end due to dense vegetation and barbed wire. No permit was found authorizing this encroachment. CVFPB will need to review crossing to determine owner. The UCIP inspection was completed with GEI staff, P. Espinoza. (H. Dunn – GEI)04/09/2014 Dense vegetation limits the inspector's visibility to identify signs of pipe failure (leaks) along the landward slope. Recommend removing vegetation along pipe alignment to conduct proper inspection of structure. (W. Wylie - DWR UCIP)

LS view: Headwall barely visible at toe from crown.

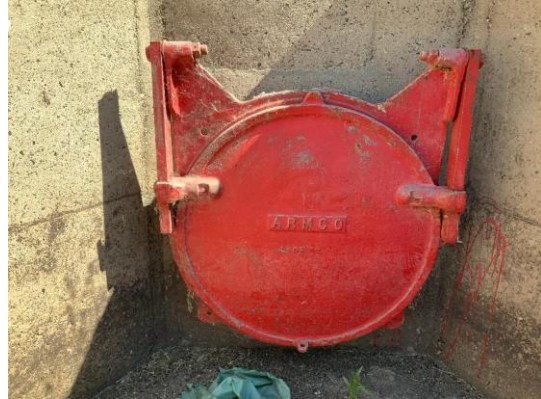
Photo 2 of 2 : UCIP_SP_2024_83309_99658.jpg

WS view: Close up of flapgate at toe.

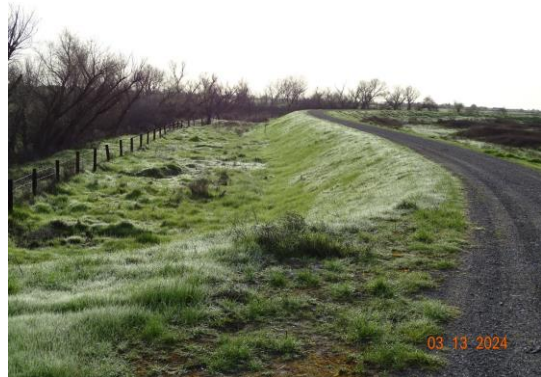
Photo 1 of 1 : SP_2024_NA0010_123_98_20240326_00294.jpg

LM Start	0.69	Rating **	A	Issue No.	98
LM End	0.69	Issue Type +	Ma	Location *	LS
Category	Earthen Levee			GPS Latitude/Longitude	
				Start	End
Item	Vegetation			37.273083°	37.273083°
				-120.814567°	-120.814567°
DWR ID	DWR_NA0010_05_s_2024_98				
Comment Code					
V1 : Control annual grass and weeds on the levee slopes and easements.					
Inspector Comment

View of the landside slope looking upstream. (Spring 2024)

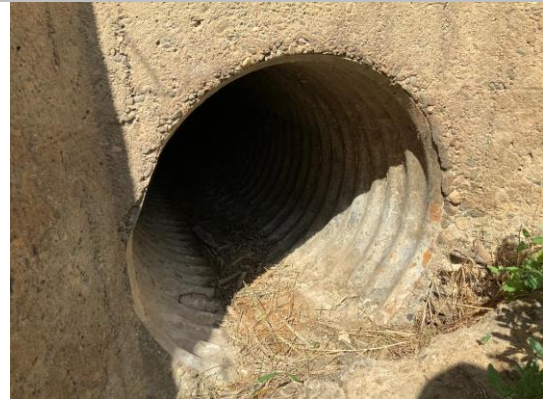
Photo 1 of 2 : UCIP_SP_2024_83314_99663.jpg

Comment Code						
Inspector Comment						
DS_ID:19759 FS_ID:83314 EP_NO: N/A Repair Type: No Action Needed EVAL Issue: Crossing Status: Found UCIP Comments: 04/25/2024 Record updated from Non-Urgent to No Action Needed. DMP internal video inspection has found none or minor pipe defects. (M. Thao - DWR UCIP) 12/20/2022 Record updated from Urgent to Non-Urgent. Pipe has been CIPP lined. LOF of crossing is less or equal to 4. Recommend next video inspection in 5 years. (O. Yakimov - DWR UCIP) 06/01/2021 Record has been upgraded from No Action Needed to Urgent. DWR DMP internal inspection has found pipe integrity issues. LOF of crossing is greater than or equal to 5 and less than 6. Crossing will be monitored until funding becomes available to address the issues. No permit was found authorizing this encroachment. CVFPB will need to review crossing to determine owner. The UCIP inspection was completed with GEI staff, P. Espinoza. (H. Dunn - GEI) FIELD_STRUCT_DESC: 24-inch CIPP-lined corrugated metal gravity drainage pipe (CMP) through the levee, 14.4 feet below the crown. Flap gate on the waterside (WS) end. Concrete headwall on the landside (LS) end. Concrete U-shaped headwall on the WS end. [Additional Reference(s): DWR Levee Log, 2002, (HLM 0.84). USACE San Joaquin O&M Manual, Unit No. 601, Part No. 1, 1967, Amended in 1978, Revised 20 June 1985, (HLM 0.84). DWR As-Built Specification No. 63-25, Sheet No. 4, 9 May 1963, (HLM 0.84)]. FS Date: 6/1/2021 11:24:27 AM

LS view: Close up of pipe inlet at toe.

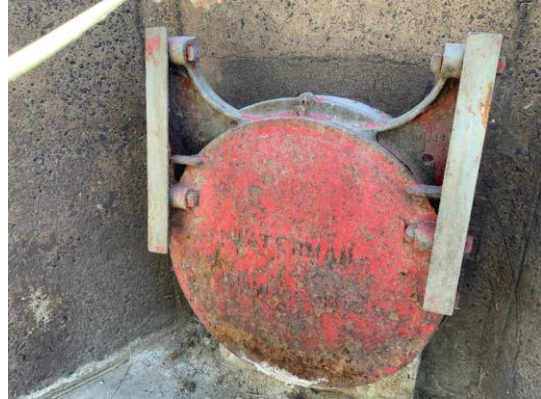
Photo 2 of 2 : UCIP_SP_2024_83314_99667.jpg

WS view: Close up of flapgate at toe.

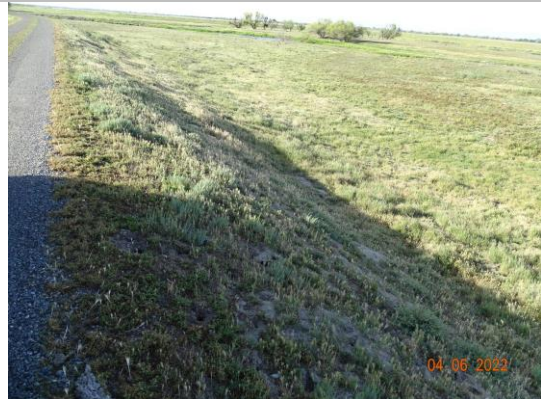
Photo 1 of 1 : SP_2024_NA0010_123_154_20240212_00043.jpg

LM Start	0.90	Rating **	A/W	Issue No.	154
LM End	0.90	Issue Type +	Ma	Location *	WS
Category	Earthen Levee			GPS Latitude/Longitude	
				Start	End
Item	Erosion / Livestock			37.271264°	37.271264°
				-120.811934°	-120.811934°
DWR ID	DWR_NA0010_05_s_2022_154				
Comment Code					
E4 : Repair the levee slope damaged by livestock and prevent large animal access.					
Inspector Comment					
Shallow depression on the lower 1/3 of the waterside slope. Possibly from livestock, but no visible trail leading to the depression. Continue to monitor.

View of minor slope erosion on the waterside. (Spring 2022)

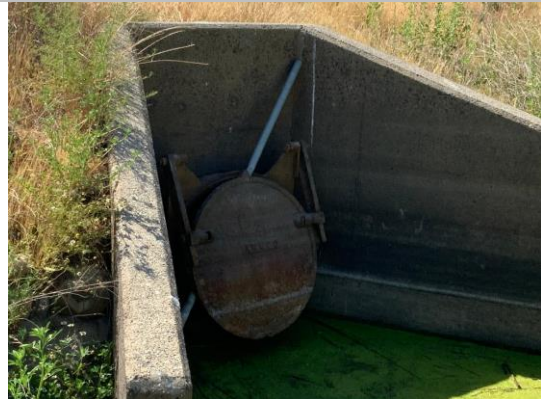
Photo 1 of 2 : UCIP_SP_2024_70989_99675.jpg

Comment Code						
Inspector Comment						
DS_ID:19760 FS_ID:70989 EP_NO: N/A Repair Type: Non-Urgent EVAL Issue: 11, Maintenance Compliance Issue Crossing Status: Found UCIP Comments: 06/1/2021 The record has been upgraded from No Action Needed to Non-Urgent. LS pipe inlet blocked by barbed wire, could not inspect. Small pipe lodged in the WS flapgate so it cannot be closed all the way, recommend removal before flood season. No permit was found authorizing this encroachment. CVFPB will need to review crossing to determine owner. The UCIP inspection was completed with GEI staff, P. Espinoza. (H. Dunn – GEI) FIELD_STRUCT_DESC: 36-inch corrugated metal gravity drainage pipe (CMP) through the levee, 21.0 feet below the crown. Flap gate on the waterside (WS) end. Concrete headwall on the landside (LS) end. Concrete U-shaped headwall on the WS end. [Additional Reference(s): DWR Levee Log, 2002, (HLM 1.44). USACE San Joaquin O&M Manual, Unit No. 601, Part No. 1, 1967, Amended in 1978, Revised 20 June 1985, (HLM 1.44). DWR As-Built Specification No. 63-25, Sheet No. 4, 9 May 1963, (HLM 1.44)]. FS Date: 6/1/2021

WS view: Close up of flapgate at toe, 1 of 2 photos.

WS view: Close up of flapgate at toe with bar sticking through, 2 of 2 photos.

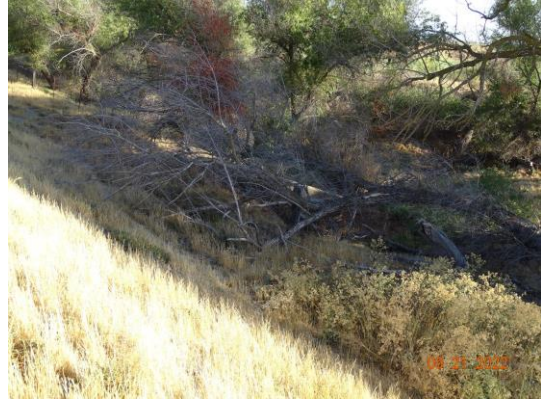
Photo 1 of 1 : SP_2024_NA0010_123_159_20240212_00046.jpg

LM Start	1.47	Rating **	M	Issue No.	159
LM End	1.47	Issue Type +	Ma	Location *	LS
Category	Earthen Levee			GPS Latitude/Longitude	
				Start	End
Item	Trim / Thin Trees			37.265605°	37.265605°
				-120.804784°	-120.804784°
DWR ID	DWR_NA0010_05_f_2022_159				
Comment Code					
T2 : Tree or limb.					
Inspector Comment					
Downed tree branch on the landside toe.

Fallen tree on the landside slope and toe. (Fall 2022)

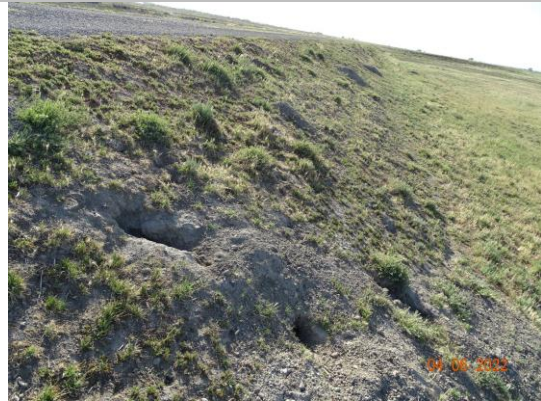
Photo 1 of 1 : SP_2024_NA0010_123_156_20240212_00044.jpg

LM Start	1.53	Rating **	U	Issue No.	156
LM End	1.53	Issue Type +	Ma	Location *	WS
Category	Earthen Levee			GPS Latitude/Longitude	
				Start	End
Item	Animal Control			37.265008°	37.265008°
				-120.804010°	-120.804010°
DWR ID	DWR_NA0010_05_s_2022_156				
Comment Code					
A3 : No rodents visible, but rodent burrows visible; need to backfill and compact or grout burrows.					
Inspector Comment					
Several rodent burrows observed. A few appear to penetrate the levee through to the landside.

Several rodent holes observed on the waterside slope. (Spring 2022)

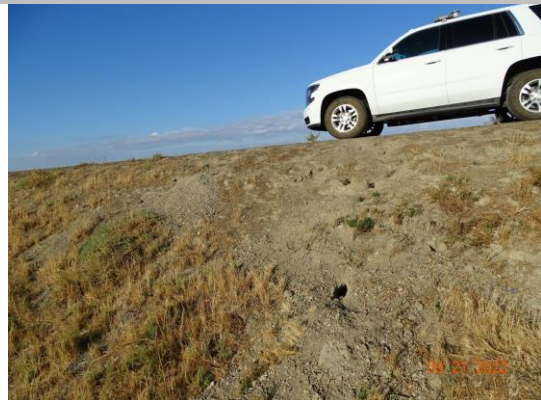
Photo 1 of 1 : SP_2024_NA0010_123_172_20240212_00057.jpg

LM Start	1.67	Rating **	M	Issue No.	172
LM End	1.67	Issue Type +	Ma	Location *	LS
Category	Earthen Levee			GPS Latitude/Longitude	
				Start	End
Item	Animal Control			37.263363°	37.263363°
				-120.802729°	-120.802729°
DWR ID	DWR_NA0010_05_f_2022_172				
Comment Code					
A3 : No rodents visible, but rodent burrows visible; need to backfill and compact or grout burrows.					
Inspector Comment

Rodent burrows on the landside slope. (Fall 2022)

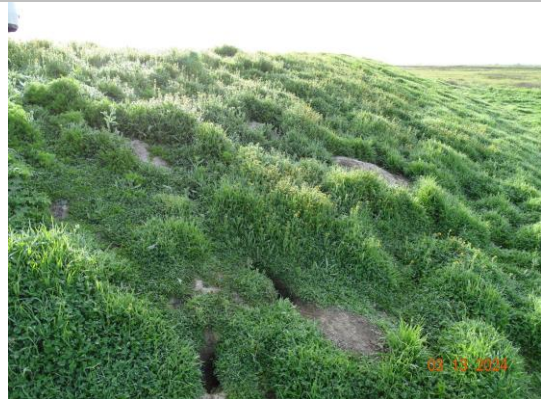
Photo 1 of 1 : SP_2024_NA0010_123_99_20240326_00295.jpg

LM Start	1.74	Rating **	M	Issue No.	99
LM End	1.74	Issue Type +	Ma	Location *	WS
Category	Earthen Levee			GPS Latitude/Longitude	
				Start	End
Item	Animal Control			37.262388 °	37.262388 °
				-120.802482 °	-120.802482 °
DWR ID	DWR_NA0010_05_s_ 2024_99				
Comment Code					
A3 : No rodents visible, but rodent burrows visible; need to backfill and compact or grout burrows.					
Inspector Comment					
Several rodent holes observed and appear to penetrate to the landside slope.

Several rodent holes noted at this section. (Spring 2024)

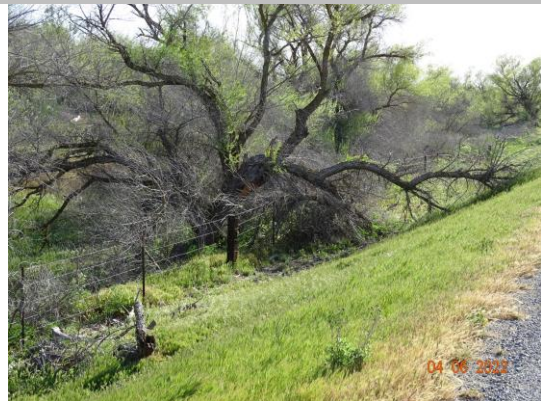
Photo 1 of 1 : SP_2024_NA0010_123_102_20240212_00010.jpg

LM Start	2.82	Rating **	M	Issue No.	102
LM End	2.82	Issue Type +	Ma	Location *	LS
Category	Earthen Levee			GPS Latitude/Longitude	
				Start	End
Item	Trim / Thin Trees			37.256805°	37.256805°
				-120.785434°	-120.785434°
DWR ID	DWR_NA0010_05_s_ 2019_102				
Comment Code					
T2 : Tree or limb.					
Inspector Comment

Tree limb has fallen on the landside slope and toe. (Spring 2022)

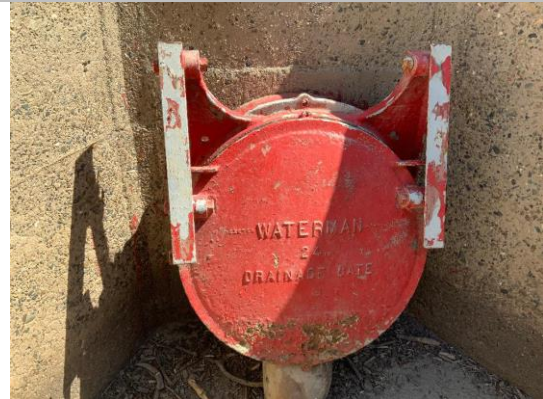
Photo 1 of 1 : UCIP_SP_2024_70990_99683.jpg

Comment Code						
Inspector Comment						
DS_ID:19809 FS_ID:70990 EP_NO: N/A Repair Type: Non-Urgent EVAL Issue: Crossing Status: Found UCIP Comments: 09/18/2023 Pipe was CIPP lined. DMP internal video inspection has found none or minor pipe defects. Recommend next video inspection in 5 years. (O. Yakimov - DWR UCIP) 06/1/2021 Record remains Non-Urgent. DWR DMP internal inspection has found pipe integrity issues. LOF of crossing is between 4.1 and 5. Crossing will be monitored until funding becomes available for rehabilitation. Barbed wire over LS end, could not inspect. No permit was found authorizing this encroachment. CVFPB will need to review crossing to determine owner. The UCIP inspection was completed with GEI staff, P. Espinoza. (H. Dunn – GEI) 04/09/2014 Log partially blocking inlet at LS toe. (W. Wylie - DWR UCIP) FIELD_STRUCT_DESC: 24-inch CIPP-lined corrugated metal gravity drainage pipe (CMP) through the levee, 15.0 feet below the crown. Flap gate on the waterside (WS) end. Concrete U-shaped headwall on each end. [Additional Reference(s): DWR Levee Log, 2002, (HLM 2.83). USACE San Joaquin O&M Manual, Unit No. 601, Part No. 1, 1967, Amended in 1978, Revised 20 June 1985, (HLM 2.85). DWR As-Built Specification No. 63-25, Sheet No. 5, 9 May 1963, (HLM 2.85)]. FS Date: 6/1/2021

WS view: Close up of flapgate at toe.

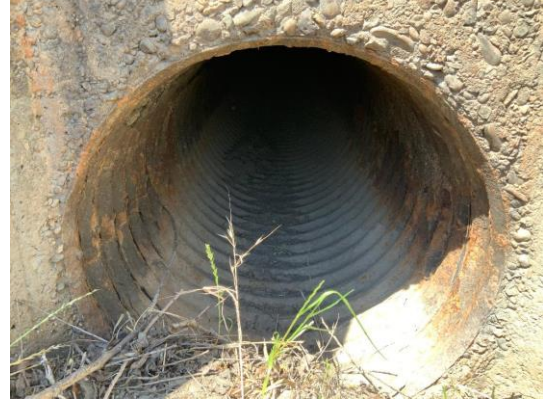
Photo 1 of 3 : UCIP_SP_2024_70991_99684.jpg

Comment Code						
Inspector Comment						
DS_ID:19810 FS_ID:70991 EP_NO: N/A Repair Type: No Action Needed EVAL Issue: Crossing Status: Found UCIP Comments: 09/18/2023 Record updated from Non-Urgent to No Action Needed. Pipe was CIPP lined. DMP internal video inspection has found none or minor pipe defects. Recommend next video inspection in 5 years. (O. Yakimov - DWR UCIP) 06/1/2021 Record remains Non-Urgent. DWR DMP internal inspection has found pipe integrity issues. LOF of crossing is between 4.1 and 5. Crossing will be monitored until funding becomes available for rehabilitation. Pipe is erroded through causing holes just behind the WS flapgate. Metal peeling away inside of pipe outlet. Flapgate is rusted with some corrosion. No permit was found authorizing this encroachment. CVFPB will need to review crossing to determine owner. The UCIP inspection was completed with GEI staff, P. Espinoza. (H. Dunn – GEI) 04/15/2014 Pipe corroded through at flapgate on WS toe. (W. Wylie - DWR UCIP) FIELD_STRUCT_DESC: 24-inch CIPP-lined corrugated metal gravity drainage pipe (CMP) through the levee, 14.7 feet below the crown. Flap gate on the waterside (WS) end. Concrete U-shaped headwall on each end. [Additional Reference(s): DWR Levee Log, 2002, (HLM 3.36). USACE San Joaquin O&M Manual, Unit No. 601, Part No. 1, 1967, Amended in 1978, Revised 20 June 1985, (HLM 3.33). DWR As-Built Specification No. 63-25, Sheet No. 5, 9 May 1963, (HLM 3.33)]. FS Date: 6/1/2021

LS view: Close up of pipe inlet at toe.

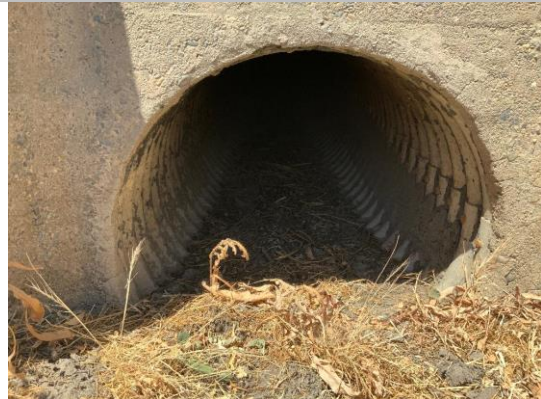
Photo 1 of 1 : UCIP_SP_2024_70992_99695.jpg

Comment Code						
Inspector Comment						
DS_ID:19811 FS_ID:70992 EP_NO: N/A Repair Type: Non-Urgent EVAL Issue: 11, Maintenance Compliance Issue Crossing Status: Found UCIP Comments: 06/1/2021 Record remains Non-Urgent. Some debris buildup within the LS pipe inlet, recommend cleaning out. No permit was found authorizing this encroachment. CVFPB will need to review crossing to determine owner. The UCIP inspection was completed with GEI staff, P. Espinoza. (H. Dunn – GEI) 04/16/2014 Sediment buildup in pipe visible from landward side--recommend contacting owner to clear pipe. (W. Wylie - DWR UCIP) FIELD_STRUCT_DESC: 24-inch corrugated metal gravity drainage pipe (CMP) through the levee, 15.0 feet below the crown. Flap gate on the waterside (WS) end. Concrete headwall on the landside (LS) end. Concrete U-shaped headwall on the WS end. [Additional Reference(s): DWR Levee Log, 2002, (HLM 3.67). USACE San Joaquin O&M Manual, Unit No. 601, Part No. 1, 1967, Amended in 1978, Revised 20 June 1985, (HLM 3.67). DWR As-Built Specification No. 63-25, Sheet No. 6, 9 May 1963, (HLM 3.67)]. FS Date: 6/1/2021

LS view: Close up of pipe inlet at toe, some debris buildup.

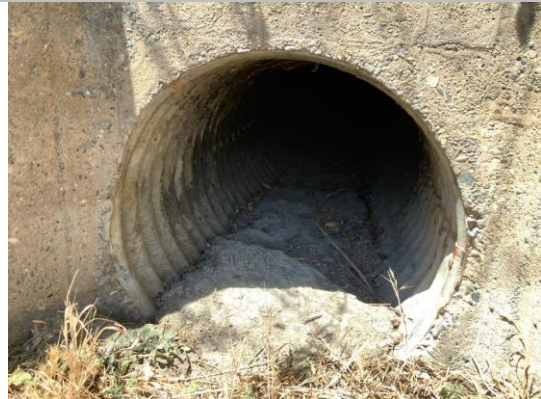
Photo 1 of 1 : UCIP_SP_2024_70993_99703.jpg

Comment Code					
Inspector Comment					
DS_ID:19769 FS_ID:70993 EP_NO: N/A Repair Type: Non-Urgent EVAL Issue: 11, Maintenance Compliance Issue Crossing Status: Found UCIP Comments: 06/1/2021 Record remains Non-Urgent. Some sediment buildup in LS pipe inlet, recommend cleaning out. No permit was found authorizing this encroachment. CVFPB will need to review crossing to determine owner. The UCIP inspection was completed with GEI staff, P. Espinoza. (H. Dunn – GEI) 04/16/2014 Sediment buildup in pipe visible from landward side--recommend contacting owner to clear pipe. (W. Wylie - DWR UCIP) FIELD_STRUCT_DESC: 24-inch corrugated metal gravity drainage pipe (CMP) through the levee, 16.0 feet below the crown. Flap gate on the waterside (WS) end. Concrete U-shaped headwall on each end. [Additional Reference(s): DWR Levee Log, 2002, (HLM 4.01). USACE San Joaquin O&M Manual, Unit No. 601, Part No. 1, 1967, Amended in 1978, Revised 20 June 1985, (HLM 4.02). DWR As-Built Specification No. 63-25, Sheet No. 6, 9 May 1963, (HLM 4.02)]. FS Date: 6/1/2021

LS view: Close up of pipe inlet with sediment buildup at toe.

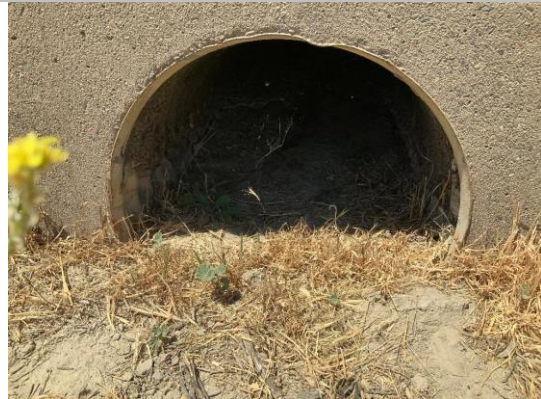
Photo 1 of 3 : UCIP_SP_2024_77866_99715.jpg

Comment Code						
Inspector Comment						
DS_ID:19770 FS_ID:77866 EP_NO: N/A Repair Type: Urgent EVAL Issue: 1, Pipe Integrity Crossing Status: Found UCIP Comments: 12/14/2022 Record updated from Non-Urgent to Urgent. DMP internal video inspection has found pipe integrity issues. LOF of crossing is between 5 and 6. Crossing will be monitored until funding becomes available to address the issues. (O.Yakimov - DWR UCIP) 06/1/2021 Record remains Non-Urgent. Sizable burrow complex on WS slope, with several holes around 3-4 inches wide, recommend filling in for levee integrity. There is also sediment buildup within the LS pipe inlet, recommend cleaning out. No permit was found authorizing this encroachment. CVFPB will need to review crossing to determine owner. The UCIP inspection was completed with GEI staff, P. Espinoza. (H. Dunn – GEI) 04/16/2014 Sediment buildup in pipe visible from landward side--recommend contacting owner to clear pipe. (W. Wylie - DWR UCIP) FIELD_STRUCT_DESC: 24-inch corrugated metal gravity drainage pipe (CMP) through the levee, 11.6 feet below the crown. Flap gate on the waterside (WS) end. Concrete headwall on the landside (LS) end. Concrete U-shaped headwall on the WS end. [Additional Reference(s): DWR Levee Log, 2002, (HLM 4.27). USACE San Joaquin O&M Manual, Unit No. 601, Part No. 1, 1967, Amended in 1978, Revised 20 June 1985, (HLM 4.27). DWR As-Built Specification No. 63-25, Sheet No. 6, 9 May 1963, (HLM 4.27)]. FS Date: 6/1/2021 1:53:07 PM

LS view: Close up of pipe inlet with sediment buildup at toe.

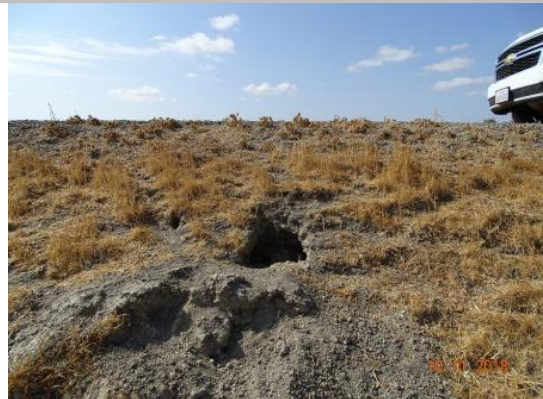
Photo 1 of 1 : SP_2024_NA0010_123_131_20240212_00027.jpg

LM Start	4.33	Rating **	A/W	Issue No.	131
LM End	4.33	Issue Type +	Ma	Location *	LS
Category	Earthen Levee			GPS Latitude/Longitude	
				Start	End
Item	Animal Control			37.245406 °	37.245406 °
				-120.759971 °	-120.759971 °
DWR ID	DWR_NA0010_05_f_2018_131				
Comment Code					
A3 : No rodents visible, but rodent burrows visible; need to backfill and compact or grout burrows.					
Inspector Comment					
Several large rodent holes are located on both sides of levee.

View of a large rodent hole in landward slope. (Fall 2018)

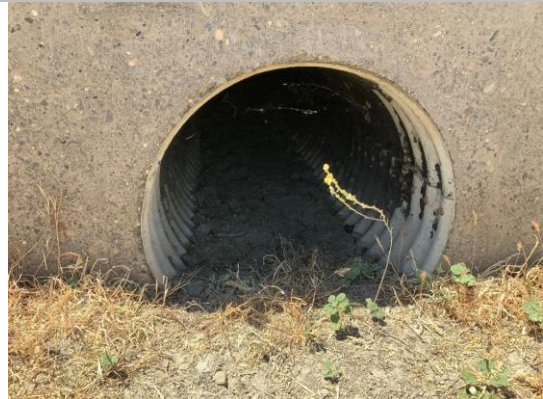
Photo 1 of 1 : UCIP_SP_2024_70995_99718.jpg

Comment Code					
Inspector Comment					
DS_ID:19771 FS_ID:70995 EP_NO: N/A Repair Type: Non-Urgent EVAL Issue: 11, Maintenance Compliance Issue Crossing Status: Found UCIP Comments: 06/1/2021 Record remains Non-Urgent. LS pipe inlet has sediment buildup inside, recommend cleaning out. No permit was found authorizing this encroachment. CVFPB will need to review crossing to determine owner. The UCIP inspection was completed with GEI staff, P. Espinoza. (H. Dunn – GEI) 04/16/2014 Sediment buildup in pipe visible from landward side--recommend contacting owner to clear pipe. (W. Wylie - DWR UCIP) FIELD_STRUCT_DESC: 24-inch corrugated metal gravity drainage pipe (CMP) through the levee, 12.0 feet below the crown. Flap gate on the waterside (WS) end. Concrete headwall on the landside (LS) end. Concrete U-shaped headwall on the WS end. [Additional Reference(s): DWR Levee Log, 2002, (HLM 4.53). USACE San Joaquin O&M Manual, Unit No. 601, Part No. 1, 1967, Amended in 1978, Revised 20 June 1985, (HLM 4.54). DWR As-Built Specification No. 63-25, Sheet No. 6, 9 May 1963, (HLM 4.54)]. FS Date: 6/1/2021

LS view: Close up of pipe inlet with sediment buildup at toe.

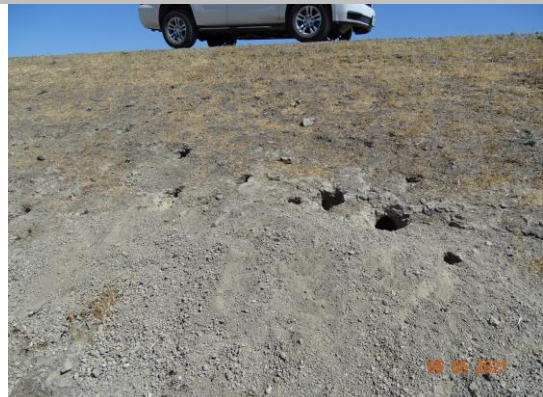
Photo 1 of 1 : SP_2024_NA0010_123_100_20240212_00008.jpg

LM Start	4.85	Rating **	M	Issue No.	100
LM End	4.85	Issue Type +	Ma	Location *	WS
Category	Earthen Levee			GPS Latitude/Longitude	
				Start	End
Item	Animal Control			37.241127°	37.241127°
				-120.752398°	-120.752398°
DWR ID	DWR_NA0010_05_s_2021_100				
Comment Code					
A1 : Exterminate rodents and backfill and compact or grout burrows.					
Inspector Comment					
Several burrows and rodents observed at this location. Bait stations have been set up.

Several rodent burrows noted at this location. (Spring 2021)

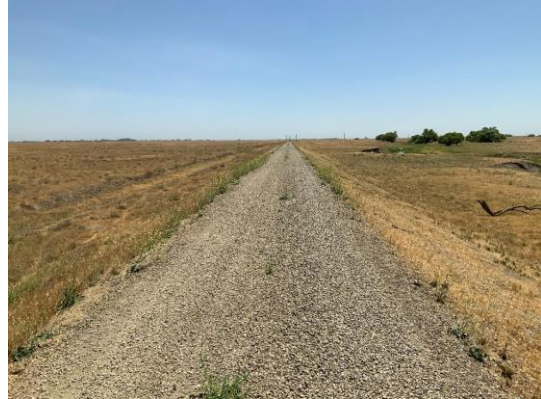
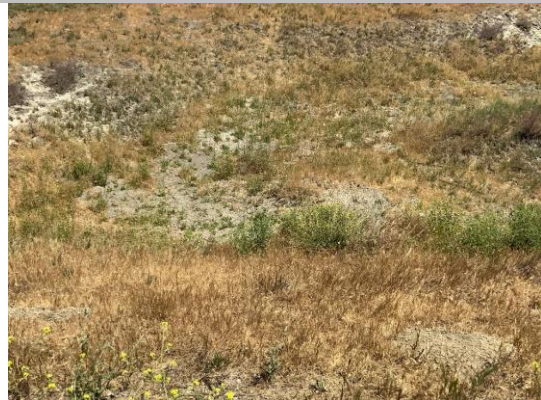
Comment Code						
Inspector Comment						
DS_ID:19773 FS_ID:77867 EP_NO: N/A Repair Type: Urgent EVAL Issue: 1, Pipe Integrity Crossing Status: Found UCIP Comments: 12/14/2022 Record updated from Non-Urgent to Urgent. DMP internal video inspection has found pipe integrity issues. LOF of crossing is between 5 and 6. Crossing will be monitored until funding becomes available to address the issues. (O.Yakimov - DWR UCIP) 06/1/2021 The record remains Non-Urgent. Crossing appears to be in good condition. No permit was found authorizing this encroachment. CVFPB will need to review crossing to determine owner. The UCIP inspection was completed with GEI staff, P. Espinoza. (H. Dunn – GEI) 04/16/2014 Heavy sediment buildup in pipe visible from landward side--recommend contacting owner to clear pipe. (W. Wylie - DWR UCIP) FIELD_STRUCT_DESC: 24-inch corrugated metal gravity drainage pipe (CMP) through the levee, 12.2 feet below the crown. Flap gate on the waterside (WS) end. Concrete headwall on the landside (LS) end. Concrete U-shaped headwall on the WS end. [Additional Reference(s): DWR Levee Log, 2002, (HLM 5.14). USACE San Joaquin O&M Manual, Unit No. 601, Part No. 1, 1967, Amended in 1978, Revised 20 June 1985, (HLM 5.15). DWR As-Built Specification No. 63-25, Sheet No. 7, 9 May 1963, (HLM 5.15)]. FS Date: 6/1/2021 1:53:28 PM

LM Start	5.15	Rating **	U	Issue No.	1324 (cont)
LM End	5.15	Issue Type +	Ma	Location *	
Category	Supplemental		GPS Latitude/Longitude		
			Start	End	
Item	DWR UCIP LMA Responsibility		37.240607°	37.240607°	
			-120.746916°	-120.746916°	
DWR ID	19773

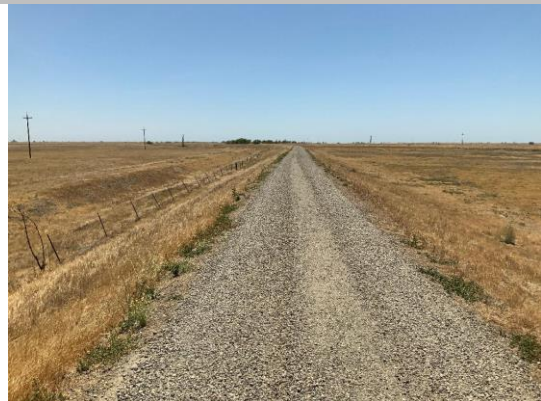
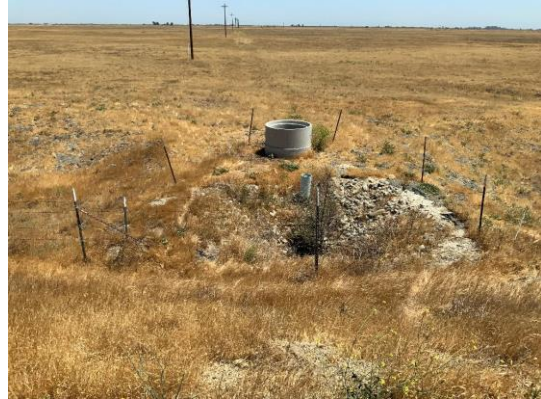
LM Start	5.58	Rating **	U	Issue No.	1325
LM End	5.58	Issue Type +	Ma	Location *	
Category	Supplemental		GPS Latitude/Longitude		
			Start	End	
Item	DWR UCIP LMA Responsibility		37.238879°	37.238879°	
			-120.739719°	-120.739719°	
DWR ID	19774

DS_ID:19774
FS_ID:77868
EP_NO: N/A
Repair Type: Urgent
EVAL Issue: 1, Pipe Integrity
Crossing Status: Found
UCIP Comments: 12/14/2022 Record updated from Non-Urgent to Urgent. DMP internal video inspection has found pipe integrity issues. LOF of crossing is between 5 and 6. Crossing will be monitored until funding becomes available to address the issues. (O.Yakimov - DWR UCIP)
06/1/2021 The record has been upgraded from No Action Needed to Non-Urgent. Crossing appears to be in good condition. No permit was found authorizing this encroachment. CVFPB will need to review crossing to determine owner. New concrete riser, plastic riser, and flowmeter off the LS toe going away from the levee. The UCIP inspection was completed with GEI staff, P. Espinoza. (H. Dunn – GEI)
FIELD_STRUCT_DESC: 24-inch corrugated metal gravity drainage pipe (CMP) through the levee, 9.5 feet below the crown. Flap gate on the waterside (WS) end. Concrete headwall on the landside (LS) end. Concrete U-shaped headwall on the WS end. [Additional Reference(s): DWR Levee Log, 2002, (HLM 5.58). USACE San Joaquin O&M Manual, Unit No. 601, Part No. 1, 1967, Amended in 1978, Revised 20 June 1985, (HLM 5.58). DWR As-Built Specification No. 63-25, Sheet No. 7, 9 May 1963, (HLM 5.58)].

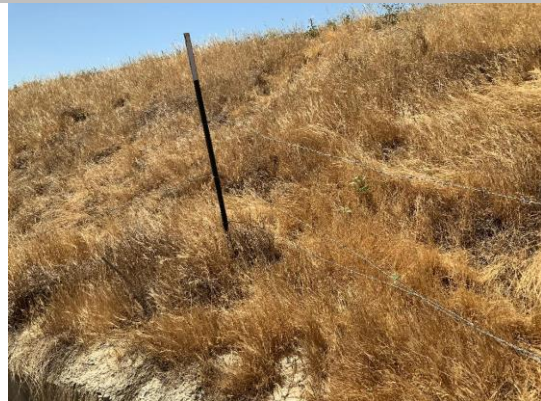
Photo 3 of 3 : UCIP_SP_2024_77868_100769.jpg

LM Start	5.58	Rating **	U	Issue No.	1325 (cont)
LM End	5.58	Issue Type +	Ma	Location *

LS view: Slope from toe.

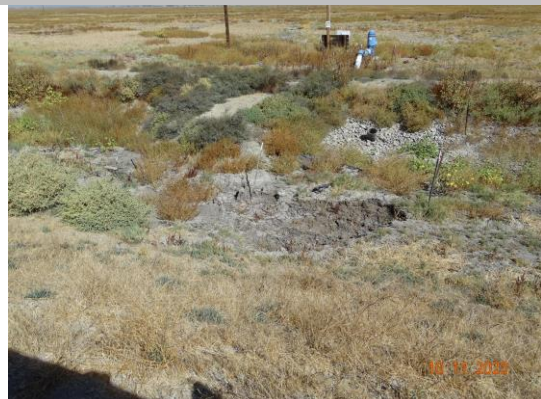
Photo 1 of 1 : SP_2024_NA0010_123_151_20240212_00040.jpg

LM Start	5.83	Rating **	A/W	Issue No.	151
LM End	5.83	Issue Type +	Ma	Location *	LS
Category	Earthen Levee			GPS Latitude/Longitude	
				Start	End
Item	Erosion / Bank Caving			37.236850°	37.236850°
				-120.736157°	-120.736157°
DWR ID	DWR_NA0010_05_f_2023_151				
Comment Code					
E1 : Note and monitor erosion site.					
Inspector Comment					
Erosion pocket appears to be just outside of the levee prism in the levee toe. Recommend repairing before it can worsen.

Erosion on the landside toe just outside the theoretical prism. (Fall 2023)

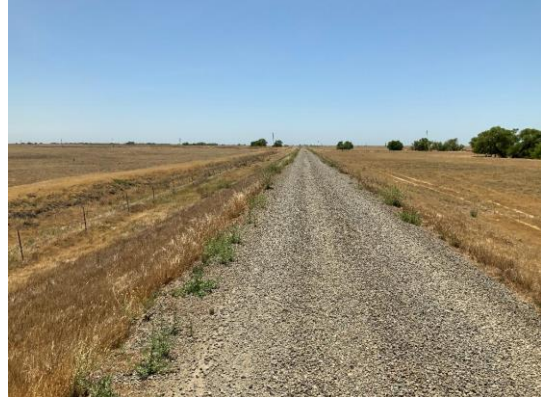
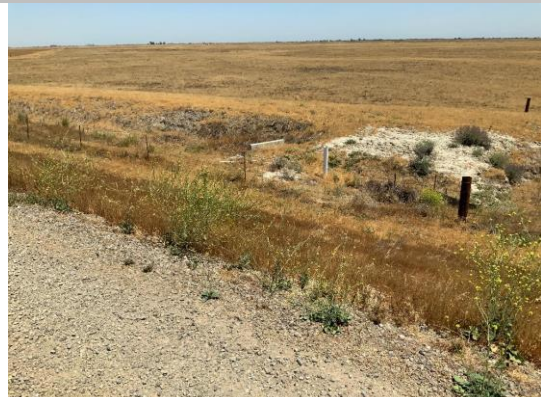
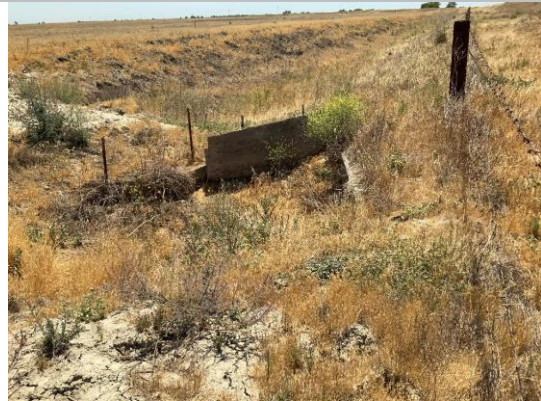
Comment Code					
Inspector Comment					
DS_ID:19775 FS_ID:70999 EP_NO: N/A Repair Type: Non-Urgent EVAL Issue: Crossing Status: Found UCIP Comments: 06/1/2021 The record has been upgraded from No Action Needed to Non-Urgent. LS inlet blocked by barbed wire and was inaccessible, could not inspect. No permit was found authorizing this encroachment. CVFPB will need to review crossing to determine owner. The UCIP inspection was completed with GEI staff, P. Espinoza. (H. Dunn – GEI) FIELD_STRUCT_DESC: 24-inch corrugated metal gravity drainage pipe (CMP) through the levee, 13.0 feet below the crown. Flap gate on the waterside (WS) end. Concrete headwall on the landside (LS) end. Concrete U-shaped headwall on the WS end. [Additional Reference(s): DWR Levee Log, 2002, (HLM 6.35). USACE San Joaquin O&M Manual, Unit No. 601, Part No. 1, 1967, Amended in 1978, Revised 20 June 1985, (HLM 6.35). DWR As-Built Specification No. 63-25, Sheet No. 8, 9 May 1963, (HLM 6.35)]. FS Date: 6/1/2021

LM Start	6.35	Rating **	M	Issue No.	1326 (cont)
LM End	6.35	Issue Type +	Ma	Location *

LS view: Headwall visible at toe behind barbed wire.

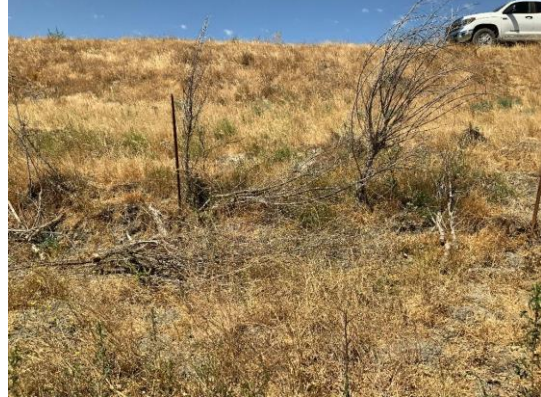
Comment Code						
Inspector Comment						
DS_ID:19762 FS_ID:71001 EP_NO: N/A Repair Type: Non-Urgent EVAL Issue: Crossing Status: Indicator Found UCIP Comments: 06/9/2021 The record remains Non-Urgent. No pipe visible on WS or LS during inspection, only indicator found. WS metal riser is bent. DWR DMP Geophysical study indicates possible presence of pipe through levee at (2305907, -13523234), coordinates have been updated. Owner needs to coordinate with the CVFPB to remove or abandon crossing according to Title 23 requirements. No permit was found authorizing this encroachment. CVFPB will need to review crossing to determine owner. The UCIP inspection was completed with GEI staff, P. Espinoza. (H. Dunn – GEI) 04/22/2014 Appears abandoned and if so should be done so properly. Slide gate rusted shut on WS slope. Unable to locate inlet or outlet. (W. Wylie - DWR UCIP) FIELD_STRUCT_DESC: 24-inch corrugated metal gravity drainage pipe (CMP) through the levee, 20.4 feet below the crown. Slide gate in a 36-inch CMP riser unit on the waterside (WS) slope. Concrete U-shaped headwall on each end. [Additional Reference(s): DWR Levee Log, 2002, (HLM 7.57). USACE San Joaquin O&M Manual, Unit No. 601, Part No. 1, 1967, Amended in 1978, Revised 20 June 1985, (HLM 7.58). DWR As-Built Specification No. 63-25, Sheet No. 9, 9 May 1963, (HLM 7.58)]. FS Date: 6/9/2021

LM Start	7.58	Rating **	M	Issue No.	1328 (cont)
LM End	7.58	Issue Type +	Ma	Location *	
Category	Supplemental			GPS Latitude/Longitude	
				Start	End
Item	DWR UCIP LMA Responsibility			37.221471°	37.221471°
				-120.713780°	-120.713780°
DWR ID	19762

LS view: Slope from toe, no pipe visible.
