Flood Control Project Maintenance
Levee Inspections
LMA District Cover Sheet

Lower San Joaquin Levee District

**Flood Control Project Maintenance
Levee Inspections
Unit Cover Sheet**

Levee Inspection Report By Mile - Spring 2024

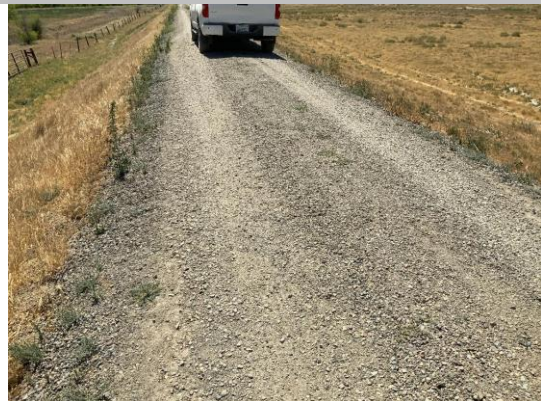
LM Start	8.46	Rating **	M	Issue No.	1330
LM End	8.46	Issue Type +	Ma	Location *	
Category	Supplemental			GPS Latitude/Longitude	
				Start	End
Item	DWR UCIP LMA Responsibility			37.209606°	37.209606°
				-120.702069°	-120.702069°
DWR ID	19763

DS_ID:19763
 FS_ID:71003
 EP_NO: N/A
 Repair Type: Non-Urgent
 EVAL Issue:
 Crossing Status: Found
 UCIP Comments: 06/9/2021 The record remains Non-Urgent. Barbed wire over LS pipe inlet, limited inspection due to inaccessability. No permit was found authorizing this encroachment. CVFPB will need to review crossing to determine owner. The UCIP inspection was completed with GEI staff, P. Espinoza. (H. Dunn – GEI) 04/22/2014
 Pipe filled with silt on LS toe and should be cleared. (W. Wylie - DWR UCIP)
 FIELD_STRUCT_DESC: 24-inch corrugated metal gravity drainage pipe (CMP) through the levee, 16.0 feet below the crown. Flap gate on the waterside (WS) end. Concrete headwall on the landside (LS) end. Concrete U-shaped headwall on the WS end. [Additional Reference(s): DWR Levee Log, 2002, (HLM 8.45). USACE San Joaquin O&M Manual, Unit No. 601, Part No. 1, 1967, Amended in 1978, Revised 20 June 1985, (HLM 8.44). DWR As-Built Specification No. 63-25, Sheet No. 9, 9 May 1963, (HLM 8.44)].

LS view: Slidegate visible at the toe behind barbed wire.

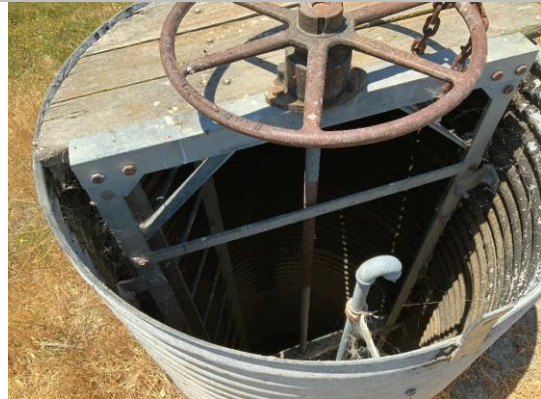
Photo 1 of 2 : UCIP_SP_2024_71009_100872.jpg

DS_ID:19766
FS_ID:71009
EP_NO: N/A
Repair Type: Non-Urgent
EVAL Issue: 4b, Safety Issue
Crossing Status: Found
UCIP Comments: 06/9/2021 The record has been upgraded from No Action Needed to Non-Urgent. LS pipe inlet was underwater during inspection, limited inspection. WS riser is missing half of the cover causing safety hazard. The LS pipe inlet is filled with sediment, recommend removal. No permit was found authorizing this encroachment. CVFPB will need to review crossing to determine owner. The UCIP inspection was completed with GEI staff, P. Espinoza. (H. Dunn – GEI)
FIELD_STRUCT_DESC: 36-inch corrugated metal gravity drainage pipe (CMP) through the levee, 14.8 feet below the crown. Slide gate in a 48-inch CMP riser unit on the waterside (WS) slope. Concrete headwall on each end. [Additional Reference(s): DWR Levee Log, 2002, (HLM 9.24). USACE San Joaquin O&M Manual, Unit No. 601, Part No. 1, 1967, Amended in 1978, Revised 20 June 1985, (HLM 9.26). DWR As-Built Specification No. 61-01, Sheet No. 52, 7 March 1961, (HLM 9.26)].

LM Start	9.28	Rating **	M	Issue No.	1331 (cont)
LM End	9.28	Issue Type +	Ma	Location *

WS view: Close up of riser and slidegate, missing partial cover.

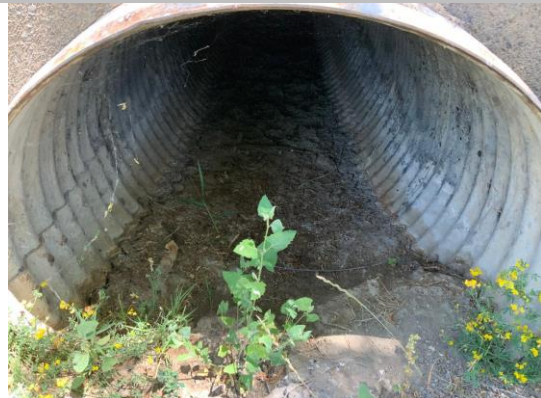
Photo 2 of 2 : UCIP_SP_2024_71009_100874.jpg

WS view: Close up of pipe inlet at toe, filled with sediment.

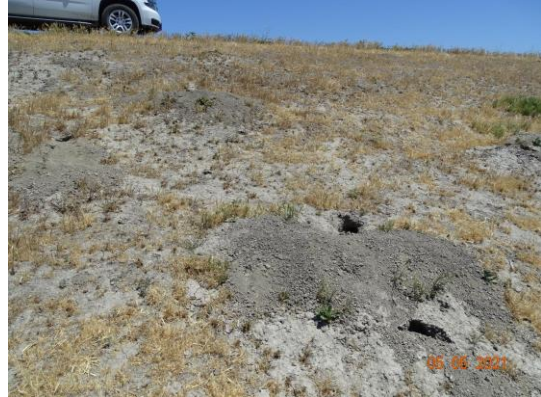
Photo 1 of 1 : SP_2024_NA0010_123_101_20240212_00009.jpg

LM Start	9.41	Rating **	M	Issue No.	101
LM End	9.45	Issue Type +	Ma	Location *	WS
Category	Earthen Levee			GPS Latitude/Longitude	
				Start	End
Item	Animal Control			37.201636°	37.201240°
				-120.688154°	-120.687686°
DWR ID	DWR_NA0010_05_s_2021_101				
Comment Code					
A3 : No rodents visible, but rodent burrows visible; need to backfill and compact or grout burrows.					
Inspector Comment

Multiple rodent holes in the waterside slope. (Spring 2021)

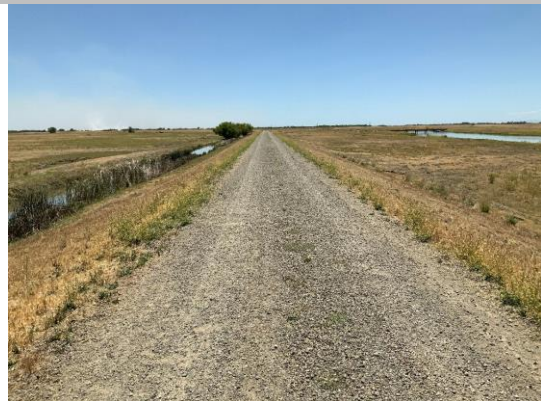
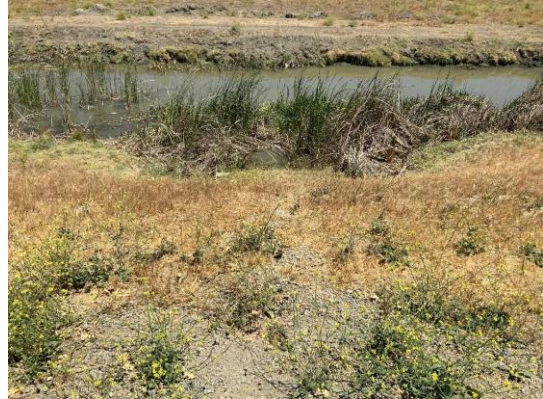
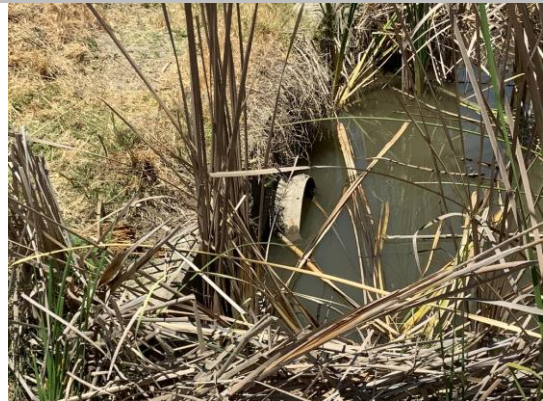
LM Start	10.06	Rating **	M	Issue No.	1332	
LM End	10.06	Issue Type +	Ma	Location *		
Category	Supplemental			GPS Latitude/Longitude		
				Start	End	
Item	DWR UCIP LMA Responsibility			37.194736°	37.194736°	
				-120.680116°	-120.680116°	
DWR ID	19767

Comment Code						
Inspector Comment						
DS_ID:19767 FS_ID:71010 EP_NO: N/A Repair Type: Non-Urgent EVAL Issue: Crossing Status: Found UCIP Comments: 06/9/2021 The record remains Non-Urgent. LS pipe inlet is underwater, could not inspect. No permit was found authorizing this encroachment. CVFPB will need to review crossing to determine owner. The UCIP inspection was completed with GEI staff, P. Espinoza. (H. Dunn – GEI) 04/22/2014 Slidegate actuator appears bent and may not work properly (WS slope). (W. Wylie - DWR UCIP) FIELD_STRUCT_DESC: 24-inch corrugated metal gravity drainage pipe (CMP) through the levee, 15.0 feet below the crown. Slide gate in a 36-inch CMP riser unit on the waterside (WS) slope. Concrete headwall on each end. [Additional Reference(s): DWR Levee Log, 2002 (HLM 10.04). USACE San Joaquin O&M Manual, Unit No. 601, Part No. 1, 1967, Amended in 1978, Revised 20 June 1985, (HLM 10.05). DWR As-Built Specification No. 61-01, Sheet No. 52, 7 March 1961, (HLM 10.05)]. FS Date: 6/9/2021

LS view: Closeup of pipe inlet at toe, underwater.

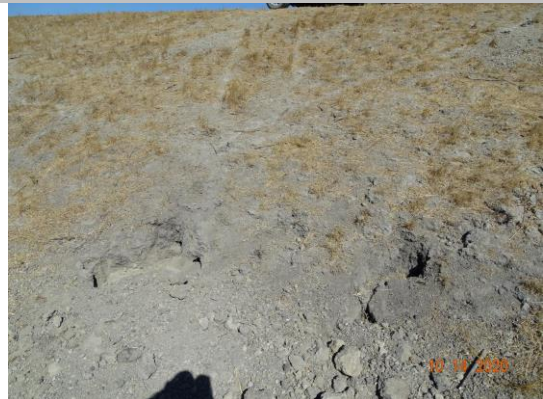
Photo 1 of 1 : SP_2024_NA0010_123_105_20240212_00011.jpg

LM Start	10.10	Rating **	M	Issue No.	105
LM End	10.10	Issue Type +	Ma	Location *	WS
Category	Earthen Levee			GPS Latitude/Longitude	
				Start	End
Item	Animal Control			37.194344°	37.194344°
				-120.679708°	-120.679708°
DWR ID	DWR_NA0010_05_f_2020_105				
Comment Code					
A3 : No rodents visible, but rodent burrows visible; need to backfill and compact or grout burrows.					
Inspector Comment

View of rodent activity in the landside slope. (Fall 2020)

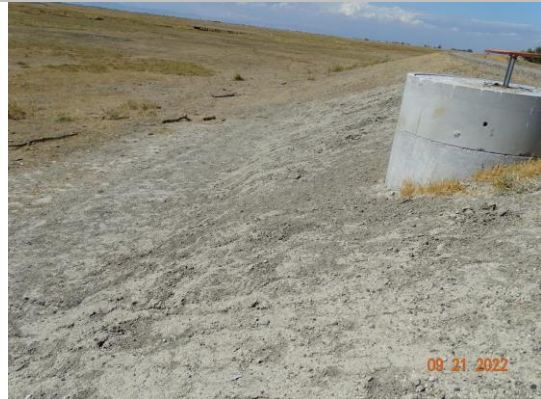
Photo 1 of 1 : SP_2024_NA0010_123_174_20240212_00059.jpg

LM Start	10.45	Rating **	A/W	Issue No.	174
LM End	10.45	Issue Type +	Ma	Location *	WS
Category	Earthen Levee			GPS Latitude/Longitude	
				Start	End
Item	Erosion / Livestock			37.190964°	37.190964°
				-120.674862°	-120.674862°
DWR ID	DWR_NA0010_05_f_2022_174				
Comment Code					
E4 : Repair the levee slope damaged by livestock and prevent large animal access.					
Inspector Comment

Erosion on the waterside slope from livestock activity. (Fall 2022)

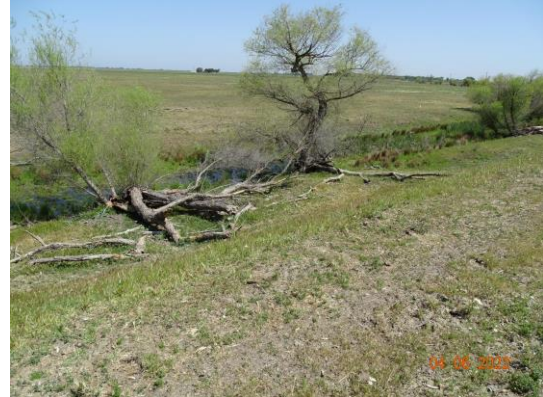
Photo 1 of 1 : SP_2024_NA0010_123_144_20240212_00034.jpg

LM Start	11.37	Rating **	M	Issue No.	144
LM End	11.37	Issue Type +	Ma	Location *	LS
Category	Earthen Levee			GPS Latitude/Longitude	
				Start	End
Item	Trim / Thin Trees			37.187792°	37.187792°
				-120.659454°	-120.659454°
DWR ID	DWR_NA0010_05_f_2018_144				
Comment Code					
T3 : Fallen tree with root ball.					
Inspector Comment					
Tree limbs on the levee toe should be moved from the easement.

View of tree limbs on levee slope. (Spring 2022)

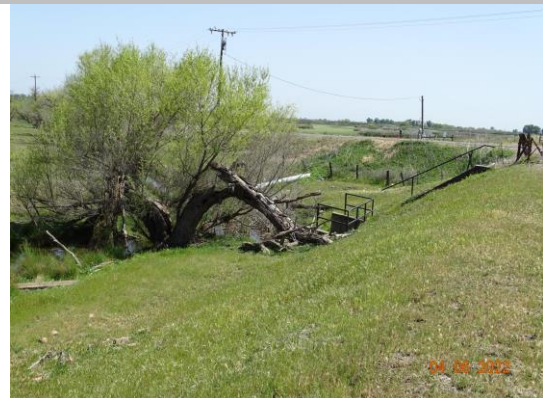
Photo 1 of 1 : SP_2024_NA0010_123_147_20240212_00036.jpg

LM Start	11.49	Rating **	U	Issue No.	147
LM End	11.49	Issue Type +	Ma	Location *	LS
Category	Earthen Levee			GPS Latitude/Longitude	
				Start	End
Item	Trim / Thin Trees			37.186482°	37.186482°
				-120.657935°	-120.657935°
DWR ID	DWR_NA0010_05_f_2021_147				
Comment Code					
T3 : Fallen tree with root ball.					
Inspector Comment					
Tree limbs are located on landside slope and toe.

Tree limbs on levee toe. (Spring 2022)

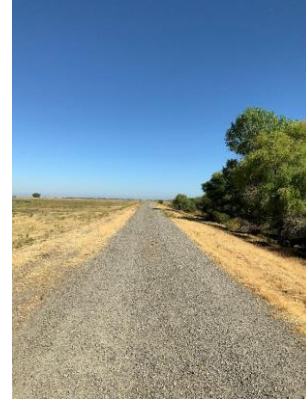
Photo 1 of 3 : UCIP_SP_2024_71012_103968.jpg

Comment Code						
Inspector Comment						
DS_ID:19768 FS_ID:71012 EP_NO: N/A Repair Type: Non-Urgent EVAL Issue: Crossing Status: Found UCIP Comments: 06/22/2021 The record has been upgraded from No Action Needed to Non-Urgent. Crossing appears to be in good condition. No permit was found authorizing this encroachment. CVFPB will need to review crossing to determine owner. The UCIP inspection was completed with GEI staff, H.Dunn. (P.Espinoza – GEI) FIELD_STRUCT_DESC: [Deadman Drain] 1 of 2: 48-inch corrugated metal gravity drainage pipe (CMP) through the levee, 16.0 feet below the crown. Slide gate in a 60-inch CMP riser unit on the waterside (WS) slope. Concrete U-shaped headwall on each end. Stairs on the landside (LS) slope. [Additional Reference(s): DWR Levee Log, 2002, (HLM 11.45). USACE San Joaquin O&M Manual, Unit No. 601, Part No. 1, 1967, Amended in 1978, Revised 20 June 1985, (HLM 11.48). DWR As-Built Specification No. 61-01, Sheet No. 53, 7 March 1961, (HLM 11.48)]. FS Date: 6/22/2021

View from levee crown.

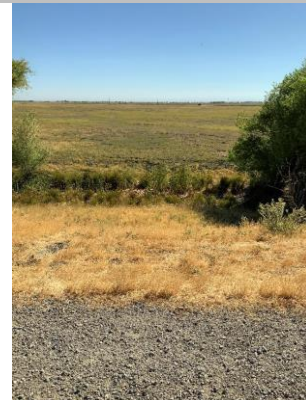
Photo 2 of 3 : UCIP_SP_2024_71012_103970.jpg

LS view of slope from levee crown.

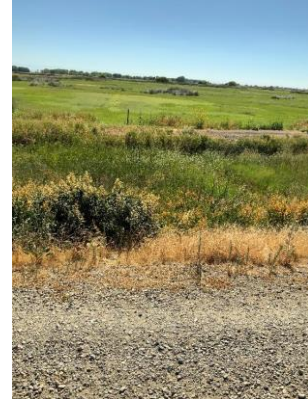
Photo 1 of 2 : UCIP_SP_2024_71016_103983.jpg

Comment Code						
Inspector Comment						
DS_ID:19705 FS_ID:71016 EP_NO: N/A Repair Type: Urgent EVAL Issue: 2b, Levee Integrity Crossing Status: Found UCIP Comments: 12/20/2022 Record remains Urgent. Pipe has been CIPP-lined. LOF of crossing is less or equal to 4. Recommend next video inspection in 5 years. Erosion around concrete headwall on WS needs to be repaired. (O.Yakimov - DWR UCIP) 06/22/2021 The record has been upgraded from No Action Needed to Urgent. DWR DMP internal inspection has found pipe integrity issues. LOF of crossing is between 4.1 and 5. Crossing will be monitored until funding becomes available for rehabilitation. Limited inspection of LS due to dense vegetation; recommend removal. Erosion around concrete headwall on WS, at least 1 foot in depth. No permit was found authorizing this encroachment. CVFPB will need to review crossing to determine owner. The UCIP inspection was completed with GEI staff, H.Dunn. (P.Espinoza – GEI) FIELD_STRUCT_DESC: 24-inch CIPP-lined corrugated metal gravity drainage pipe (CMP) through the levee, 12.5 feet below the crown. Flap gate on the waterside (WS) end. Concrete headwall on the landside (LS) end. Concrete saddle and apron on the WS end. Flashboard attachment on the LS end. [Additional Reference(s): DWR Levee Log, 2002, (HLM 11.98). USACE San Joaquin O&M Manual, Unit No. 601, Part No. 1, 1967, Amended in 1978, Revised 20 June 1985, (HLM 11.99). DWR As-Built Specification No. 61-01, Sheet No. 54, 7 March 1961, (HLM 11.99)]. FS Date: 6/22/2021

LS view: slope from crown.

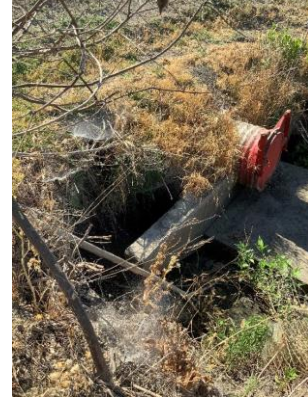
Photo 2 of 2 : UCIP_SP_2024_71016_103986.jpg

WS view: visible erosion around concrete headwall, 1 of 2 photos.

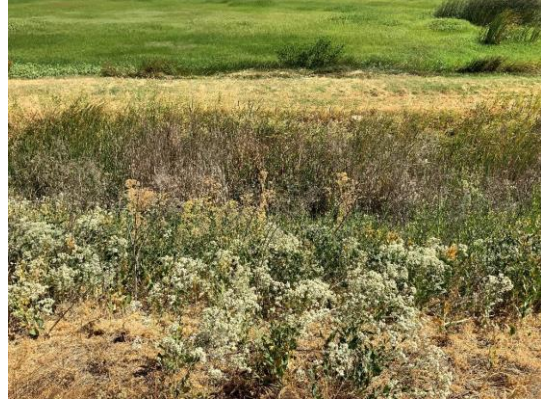
Photo 1 of 3 : UCIP_SP_2024_71017_104007.jpg

Comment Code					
Inspector Comment					
DS_ID:19706 FS_ID:71017 EP_NO: N/A Repair Type: Urgent EVAL Issue: 2b, Levee Integrity Crossing Status: Found UCIP Comments: 12/20/2022 Record remains Urgent. Pipe has been CIPP-lined. LOF of crossing is less or equal to 4. Recommend next video inspection in 5 years. Erosion around flapgate and concrete headwall on waterside needs to be addressed. (O.Yakimov - DWR UCIP) 06/22/2021 The record has been upgraded from No Action Needed to Urgent. DWR DMP internal inspection has found pipe integrity issues. LOF of crossing is between 5 and 6. Crossing will be monitored until funding becomes available to address the issues. Erosion around concrete headwall on WS, at least 1 foot in length. Limited inspection of LS due to vegetation and sediment; recommend removal. No permit was found authorizing this encroachment. CVFPB will need to review crossing to determine owner. The UCIP inspection was completed with GEI staff, H.Dunn. (P.Espinoza – GEI) FIELD_STRUCT_DESC: 24-inch CIPP-lined corrugated metal gravity drainage pipe (CMP) through the levee, 10.2 feet below the crown. Flap gate on the waterside (WS) end. Concrete headwall on the landside (LS) end. Concrete saddle and apron on the WS end. Flashboard attachment on the LS end. Pipe crosses levee at a 45-degree angle. [Additional Reference(s): DWR Levee Log, 2002, (HLM 12.38). USACE San Joaquin O&M Manual, Unit No. 601, Part No. 1, 1967, Amended in 1978, Revised 20 June 1985, (HLM 12.38). DWR As-Built Specification No. 61-01, Sheet No. 54, 7 March 1961, (HLM 12.38)]. FS Date: 6/22/2021

LS view: Slope from crown.

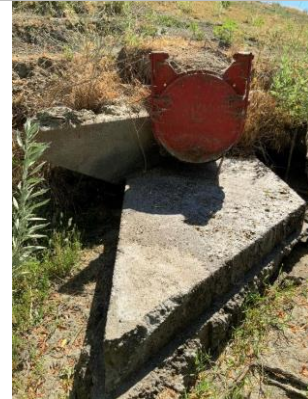
Photo 3 of 3 : UCIP_SP_2024_71017_104004.jpg

WS view: closeup of flapgate and erosion at toe, 2 of 3 photos.

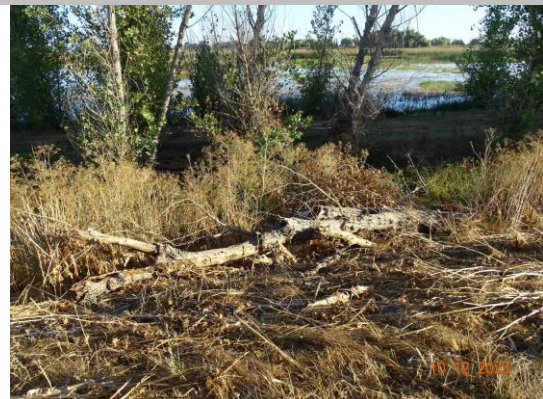
Photo 1 of 1 : SP_2024_NA0010_123_158_20240212_00045.jpg

LM Start	12.91	Rating **	M	Issue No.	158
LM End	12.92	Issue Type +	Ma	Location *	LS
Category	Earthen Levee			GPS Latitude/Longitude	
				Start	End
Item	Trim / Thin Trees			37.175803°	37.175792°
				-120.640429°	-120.640242°
DWR ID	DWR_NA0010_05_f_2019_158				
Comment Code					
T2 : Tree or limb.					
Inspector Comment					
Tree limb on the landside slope should be removed.

View of downed tree limb on the landside slope. (Fall 2023)

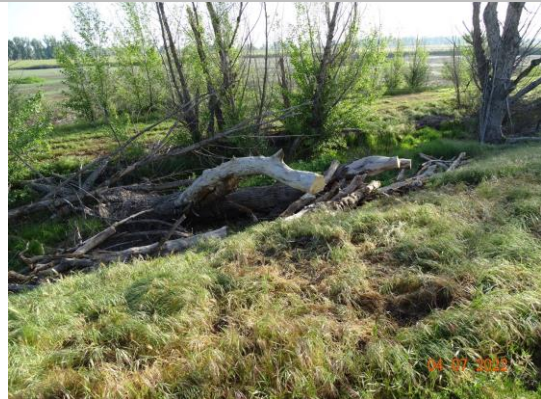
Photo 1 of 1 : SP_2024_NA0010_123_2_20240212_00002.jpg

LM Start	12.99	Rating **	M	Issue No.	2
LM End	13.01	Issue Type +	Ma	Location *	LS
Category	Earthen Levee			GPS Latitude/Longitude	
				Start	End
Item	Trim / Thin Trees			37.175638°	37.175576°
				-120.639076°	-120.638755°
DWR ID	DWR_NA0010_05_s_2016_2				
Comment Code					
T2 : Tree or limb.					
Inspector Comment					
There are several downed trees on landside toe.

Looking west at down tree at landward toe. (Spring 2022)

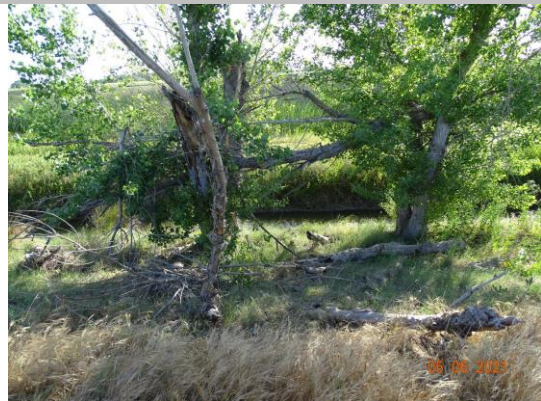
Photo 1 of 1 : SP_2024_NA0010_123_112_20240212_00014.jpg

LM Start	13.37	Rating **	U	Issue No.	112
LM End	13.37	Issue Type +	Ma	Location *	LS
Category	Earthen Levee			GPS Latitude/Longitude	
				Start	End
Item	Trim / Thin Trees			37.172079°	37.172033°
				-120.634036°	-120.634005°
DWR ID	DWR_NA0010_05_s_2021_112				
Comment Code					
T2 : Tree or limb.					
Inspector Comment

View of tree limbs on the landside toe and slope. (Spring 2021)

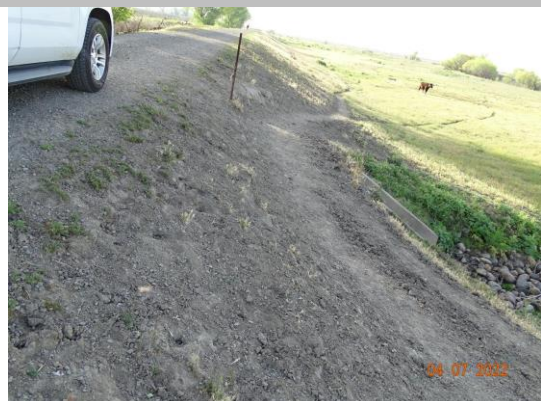
Photo 1 of 1 : SP_2024_NA0010_123_170_20240212_00055.jpg

LM Start	13.42	Rating **	U	Issue No.	170
LM End	13.42	Issue Type +	Ma	Location *	WS
Category	Earthen Levee			GPS Latitude/Longitude	
				Start	End
Item	Erosion / Livestock			37.171545°	37.171545°
				-120.633480°	-120.633480°
DWR ID	DWR_NA0010_05_s_2022_170				
Comment Code					
E4 : Repair the levee slope damaged by livestock and prevent large animal access.					
Inspector Comment

Erosion from livestock on the waterside slope around the pipe crossing. (Spring 2022)

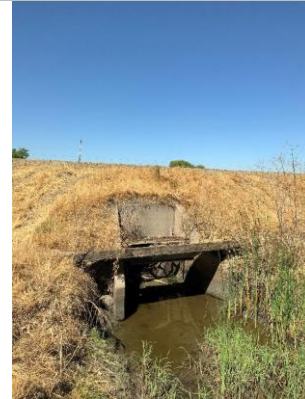
Photo 1 of 2 : UCIP_SP_2024_71019_104014.jpg

Comment Code						
Inspector Comment						
DS_ID:19708 FS_ID:71019 EP_NO: N/A Repair Type: Non-Urgent EVAL Issue: 11, Maintenance Compliance Issue Crossing Status: Found UCIP Comments: 06/22/2021 The record remains Non-Urgent. Limited inspection of LS due to water around the inlet at the time of survey. LS inlet has sediment buildup, recommend removal. No permit was found authorizing this encroachment. CVFPB will need to review crossing to determine owner. The UCIP inspection was completed with GEI staff, H.Dunn. (P.Espinoza – GEI) 04/22/2014 Some erosion around headwall on the WS toe and there are animal burrows on both slopes. (W. Wylie - DWR UCIP) FIELD_STRUCT_DESC: 48-inch corrugated metal gravity drainage pipe (CMP) through the levee, 10.0 feet below the crown. Flap gate on the waterside (WS) end. Flashboard attachment in a concrete U-shaped headwall on the landside (LS) end. Concrete U-shaped headwall on the WS end. [Additional Reference(s): DWR Levee Log, 2002, (HLM 13.40). USACE San Joaquin O&M Manual, Unit No. 601, Part No. 1, 1967, Amended in 1978, Revised 20 June 1985, (HLM 13.40)]. FS Date: 6/22/2021

LS view from toe: concrete headwall and inlet pipe. Slope visible in background.

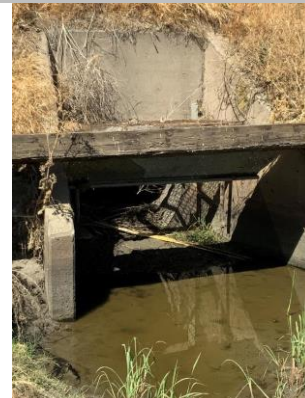
Photo 2 of 2 : UCIP_SP_2024_71019_104015.jpg

LS view from toe: closeup of concrete headwall and inlet.

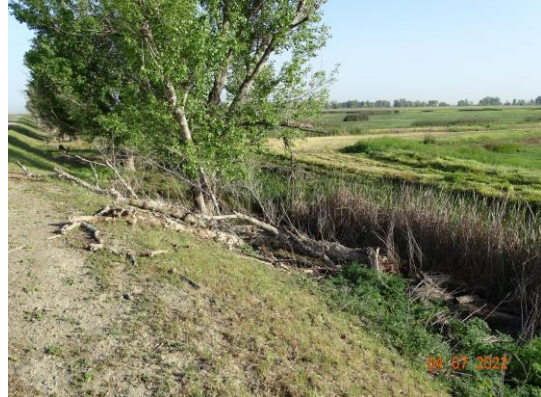
Photo 1 of 1 : SP_2024_NA0010_123_209_20240212_00073.jpg

LM Start	13.44	Rating **	U	Issue No.	209
LM End	13.44	Issue Type +	Ma	Location *	LS
Category	Earthen Levee			GPS Latitude/Longitude	
				Start	End
Item	Trim / Thin Trees			37.171249°	37.171249°
				-120.633157°	-120.633157°
DWR ID	DWR_NA0010_05_s_2020_209				
Comment Code					
T2 : Tree or limb.					
Inspector Comment					
Dead tree should be removed before it can damage the levee.

Dead tree falling over on the landside toe. (Spring 2022)

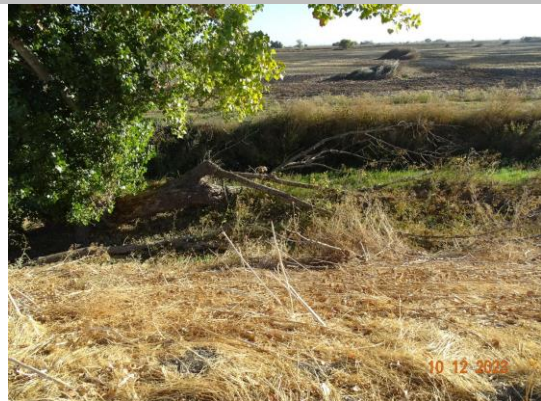
Photo 1 of 1 : SP_2024_NA0010_123_180_20240212_00061.jpg

LM Start	13.49	Rating **	U	Issue No.	180
LM End	13.49	Issue Type +	Ma	Location *	LS
Category	Earthen Levee			GPS Latitude/Longitude	
				Start	End
Item	Trim / Thin Trees			37.170689°	37.170689°
				-120.632569°	-120.632569°
DWR ID	DWR_NA0010_05_f _ 2022_180				
Comment Code					
T2 : Tree or limb.					
Inspector Comment					
Tree trunk and limbs on the levee toe.

Fallen trees and broken limbs on the landside slope and toe. (Fall 2023)

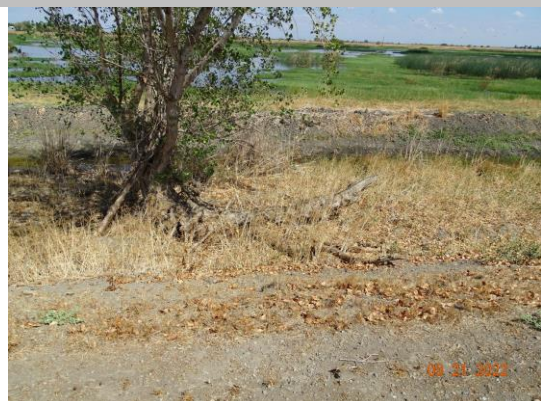
Photo 1 of 1 : SP_2024_NA0010_123_182_20240212_00062.jpg

LM Start	13.59	Rating **	M	Issue No.	182
LM End	13.59	Issue Type +	Ma	Location *	LS
Category	Earthen Levee			GPS Latitude/Longitude	
				Start	End
Item	Trim / Thin Trees			37.169572°	37.169572°
				-120.631384°	-120.631384°
DWR ID	DWR_NA0010_05_s_2024_182				
Comment Code					
T2 : Tree or limb.					
Inspector Comment					
Fallen limb has been pushed on to levee toe.

Broken tree limbs on the landside toe and slope. (Fall 2022)

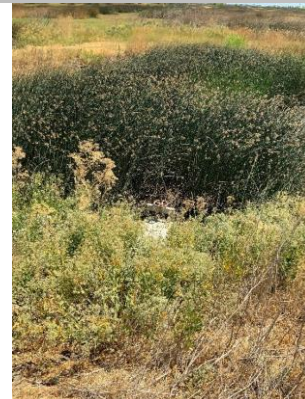
Photo 2 of 3 : UCIP_SP_2024_71020_104017.jpg

LS view of slope to toe from crown.

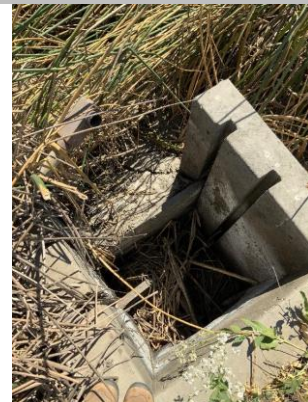
Photo 2 of 3 : UCIP_SP_2024_71023_104026.jpg

LS view: concrete wier intake structure at toe.

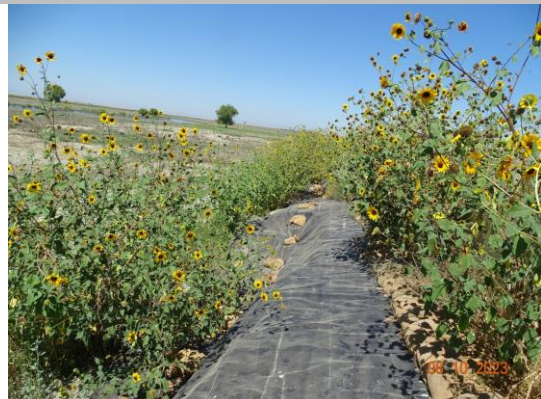
Photo 1 of 1 : SP_2024_NA0010_123_4_20240212_00005.jpg

8/10/2023: From 2022 to present, significant changes were observed during the annual survey, scarp increased to 6 feet and length to 500 feet.

08/03/2022: No significant changes were observed since the previous inspection.

07/21/2021: This site was discovered during the DWR Spring 2021 Levee Inspections. There is a series of erosion pockets along the lower levee slope and toe, ranging from 3 ft in length to 15 ft and 2 ft to 7 ft in scarp height. There are several of rodent holes on the entire levee slope.

8/10/2023: View of the erosion under wavewash protection.

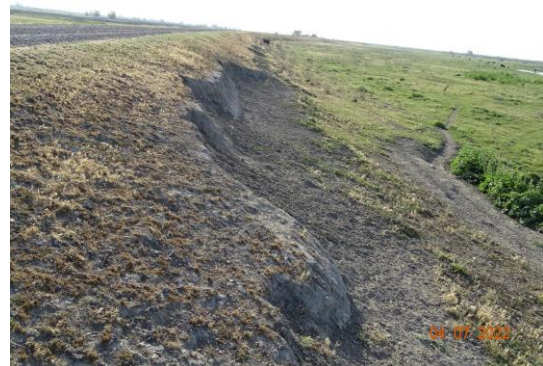
Photo 1 of 1 : SP_2024_NA0010_123_119_20240212_00018.jpg

LM Start	14.47	Rating **	U	Issue No.	119
LM End	14.49	Issue Type +	Ma	Location *	WS
Category	Earthen Levee			GPS Latitude/Longitude	
				Start	End
Item	Erosion / Bank Caving			37.162647°	37.162540°
				-120.618376°	-120.618091°
DWR ID	DWR_NA0010_05_s_2021_119				
Comment Code					
E2 : Schedule repair of erosion site prior to the next inspection.					
Inspector Comment					
Slope erosion on the waterside slope. Possibly caused by livestock.

Looking upstream along the waterside slope at erosion spots. (Spring 2022)

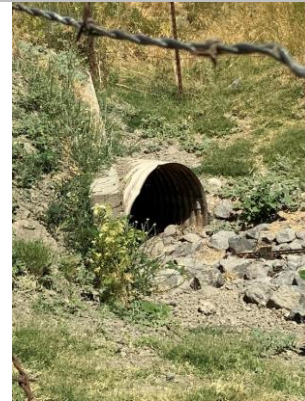
Photo 1 of 3 : UCIP_SP_2024_81020_104051.jpg

Comment Code					
Inspector Comment					
DS_ID:19712 FS_ID:81020 EP_NO: N/A Repair Type: Urgent EVAL Issue: 1, Pipe Integrity Crossing Status: Found UCIP Comments: 09/19/2023 Record updated from Non-Urgent to Urgent. DMP internal video inspection has found severe pipe defects. Crossing will be monitored until funding becomes available to address the issues. (O. Yakimov - DWR UCIP) 06/22/2021 The record remains Non-Urgent. Limited inspection on LS due to barbed wire and access issues. Build up of sediment at WS outlet pipe and LS inlet pipe; recommend removal. Some erosion along the WS slope, less than 1 foot. No permit was found authorizing this encroachment. CVFPB will need to review crossing to determine owner. The UCIP inspection was completed with GEI staff, H.Dunn. (P.Espinoza – GEI) 04/23/2014 Minor erosion at headwall on WS toe. (W. Wylie - DWR UCIP) FIELD_STRUCT_DESC: 36-inch corrugated metal gravity drainage pipe (CMP) through the levee, 11.9 feet below the crown. Flap gate on the waterside (WS) end. Concrete headwall on each end. [Additional Reference(s): DWR Levee Log, 2002, (HLM 15.08). USACE San Joaquin O&M Manual, Unit No. 601, Part No. 1, 1967, Amended in 1978, Revised 20 June 1985, (HLM 15.09)]. FS Date: 6/22/2021

LS view: Closeup of inlet pipe.

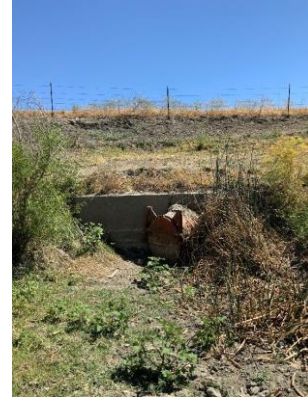
Photo 2 of 3 : UCIP_SP_2024_81020_104048.jpg

WS view from toe: concrete headwall, flapgate, and outlet pipe. Erosion along slope visible in background.

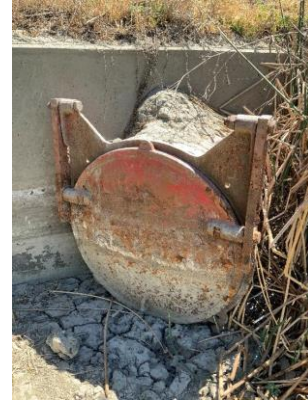
Photo 3 of 3 : UCIP_SP_2024_81020_104049.jpg

WS view from toe: closeup of flapgate and outlet pipe.

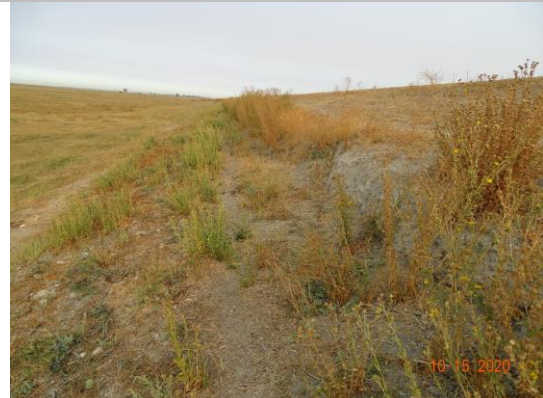
Photo 1 of 1 : SP_2024_NA0010_123_110_20240212_00013.jpg

Erosion along the waterside slope. (Fall 2020)

LM Start	15.21	Rating **	M	Issue No.	110
LM End	15.26	Issue Type +	Ma	Location *	WS
Category	Earthen Levee			GPS Latitude/Longitude	
				Start	End
Item	Erosion / Bank Caving			37.155782°	37.155337°
				-120.608075°	-120.607449°
DWR ID	DWR_NA0010_05_f_2020_110				
Comment Code					
E2 : Schedule repair of erosion site prior to the next inspection.					
Inspector Comment

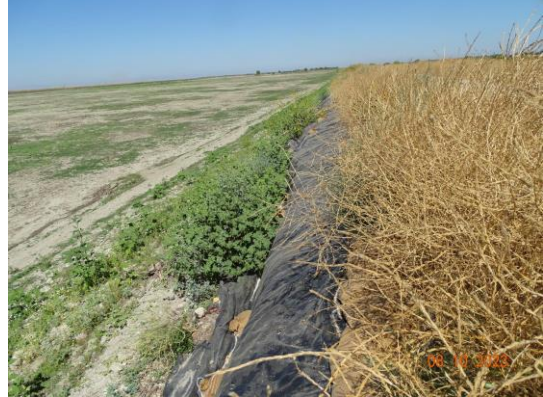
Photo 1 of 2 : SP_2024_NA0010_123_3_20240212_00003.jpg

8/10/2023: From 2022 to present, significant changes were observed during the annual survey, scarp increased to 6 feet.

08/03/2022: From 2021 to present, no significant changes were observed during the annual survey. The erosion length was updated to 80 ft based on more accurate field measurements.

8/10/2023: View of the erosion looking downstream under wavewash protection.

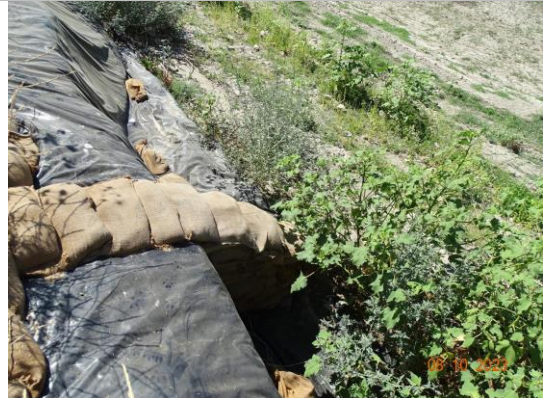
Photo 2 of 2 : SP_2024_NA0010_123_3_20240212_00004.jpg

8/10/2023: Cloes-up view of erosion.

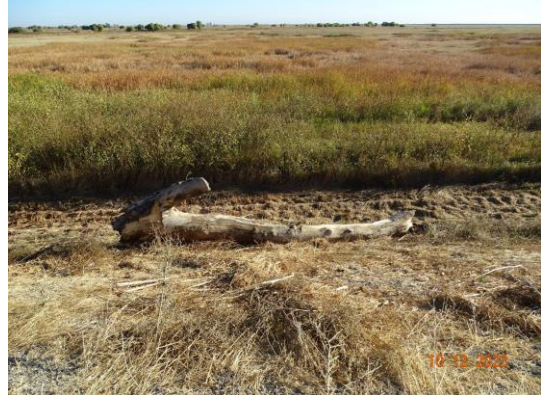
Photo 1 of 1 : SP_2024_NA0010_123_153_20240212_00042.jpg

LM Start	15.37	Rating **	A/W	Issue No.	153
LM End	15.37	Issue Type +	En	Location *	LS
Category	Earthen Levee			GPS Latitude/Longitude	
				Start	End
Item	Encroachments			37.154232°	37.154232°
				-120.605883°	-120.605883°
DWR ID	DWR_NA0010_05_f_2023_153				
Comment Code					
PR : Prunings					
Inspector Comment

Cut tree limb left on the landside toe. (Fall 2023)

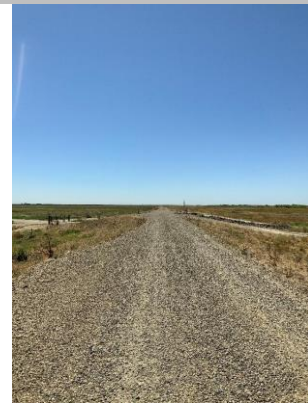
Photo 1 of 3 : UCIP_SP_2024_71026_104037.jpg

Comment Code					
Inspector Comment					
DS_ID:19713 FS_ID:71026 EP_NO: N/A Repair Type: Non-Urgent EVAL Issue: Crossing Status: Found UCIP Comments: 06/22/2021 The record remains Non-Urgent. Crossing appears to be in good condition. No permit was found authorizing this encroachment. CVFPB will need to review crossing to determine owner. The UCIP inspection was completed with GEI staff, H.Dunn. (P.Espinoza – GEI) 04/23/2014 Sediment buildup in pipe visible from landward side--recommend contacting owner to clear pipe. (W. Wylie - DWR UCIP) FIELD_STRUCT_DESC: 24-inch corrugated metal gravity drainage pipe (CMP) through the levee, 11.0 feet below the crown. Flap gate on the waterside (WS) end. Concrete headwall on each end. [Additional Reference(s): DWR Levee Log, 2002, (HLM 15.74). USACE San Joaquin O&M Manual, Unit No. 601, Part No. 1, 1967, Amended in 1978, Revised 20 June 1985, (HLM 15.74)]. FS Date: 6/22/2021

View from levee crown.

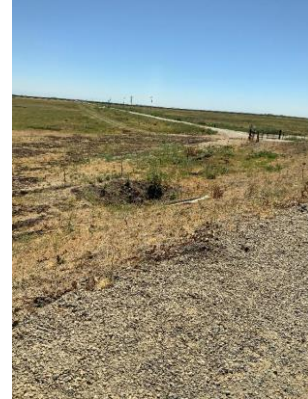
Photo 2 of 3 : UCIP_SP_2024_71026_104039.jpg

LS view of slope to toe from crown.

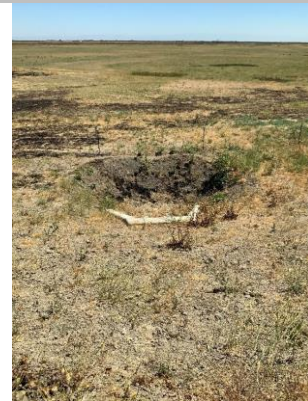
Photo 3 of 3 : UCIP_SP_2024_71026_104042.jpg

LS view of slope to toe. Concrete headwall visible at toe.

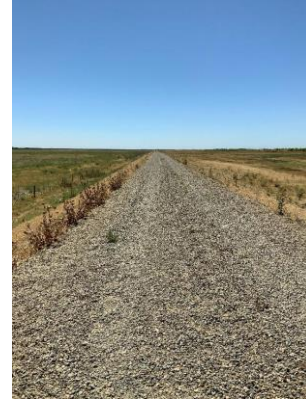
Photo 1 of 3 : UCIP_SP_2024_71028_104057.jpg

Comment Code						
Inspector Comment						
DS_ID:19715 FS_ID:71028 EP_NO: N/A Repair Type: Non-Urgent EVAL Issue: Crossing Status: Found UCIP Comments: 06/22/2021 The record remains Non-Urgent. Crossing appears to be in good condition. No permit was found authorizing this encroachment. CVFPB will need to review crossing to determine owner. The UCIP inspection was completed with GEI staff, H.Dunn. (P.Espinoza – GEI) 04/23/2014 Excess vegetation at inlet on LS toe should be cleared. (W. Wylie - DWR UCIP) FIELD_STRUCT_DESC: 24-inch corrugated metal gravity drainage pipe (CMP) through the levee, 12.0 feet below the crown. Flap gate on the waterside (WS) end. Concrete headwall on the landside (LS) end. Concrete saddle and apron on the WS end. [Additional Reference(s): DWR Levee Log, 2002, (HLM 15.79). USACE San Joaquin O&M Manual, Unit No. 601, Part No. 1, 1967, Amended in 1978, Revised 20 June 1985, (HLM 15.80)]. FS Date: 6/22/2021

View from levee crown.

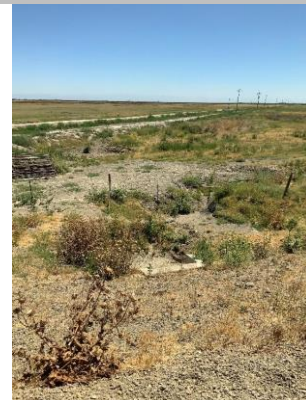
Photo 2 of 3 : UCIP_SP_2024_71028_104056.jpg

LS view of slope to toe from crown. Concrete headwall visible at toe.

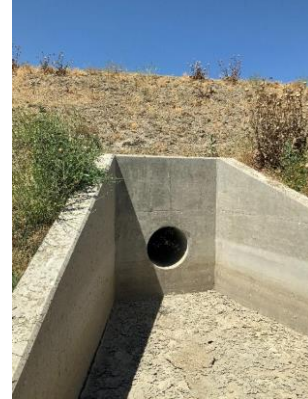
Photo 3 of 3 : UCIP_SP_2024_71028_104061.jpg

LS view from toe: concrete headwall and inlet. Slope visible in background.

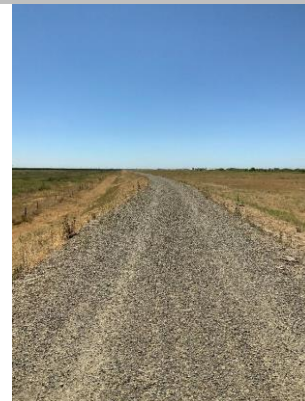
Photo 1 of 3 : UCIP_SP_2024_71029_104063.jpg

Comment Code					
Inspector Comment					
DS_ID:19716 FS_ID:71029 EP_NO: N/A Repair Type: Non-Urgent EVAL Issue: Crossing Status: Found UCIP Comments: 06/22/2021 The record remains Non-Urgent. Crossing appears to be in good condition. No permit was found authorizing this encroachment. CVFPB will need to review crossing to determine owner. The UCIP inspection was completed with GEI staff, H.Dunn. (P.Espinoza – GEI) 04/23/2014 Pipe heavily silted on LS toe. (W. Wylie - DWR UCIP) FIELD_STRUCT_DESC: 24-inch corrugated metal gravity drainage pipe (CMP) through the levee, 10.5 feet below the crown. Flap gate on the waterside (WS) end. Concrete headwall on each end. [Additional Reference(s): DWR Levee Log, 2002, (HLM 16.66). USACE San Joaquin O&M Manual, Unit No. 601, Part No. 1, 1967, Amended in 1978, Revised 20 June 1985, (HLM 16.67). DWR As-Built Specification No. 61-01, Sheet No. 57, 7 March 1961, (HLM 16.67)]. FS Date: 6/22/2021

View from levee crown.

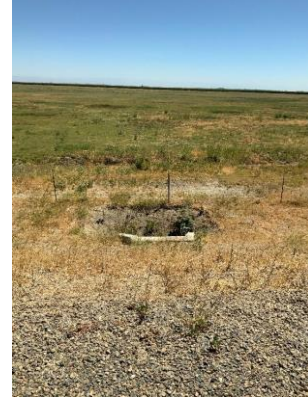
Photo 2 of 3 : UCIP_SP_2024_71029_104064.jpg

LM Start	16.68	Rating **	M	Issue No.	1347 (cont)
LM End	16.68	Issue Type +	Ma	Location *	
Category	Supplemental			GPS Latitude/Longitude	
				Start	End
Item	DWR UCIP LMA Responsibility			37.138760 °	37.138760 °
				-120.592393 °	-120.592393 °
DWR ID	19716

LS view of slope to toe from crown.

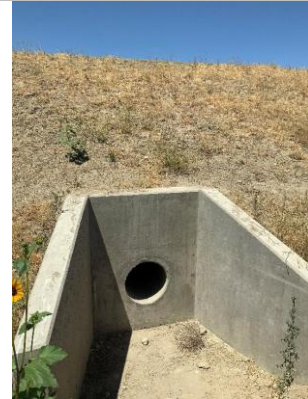
Photo 3 of 3 : UCIP_SP_2024_71029_104068.jpg

LS view from toe: concrete headwall and inlet. Slope visible in background.

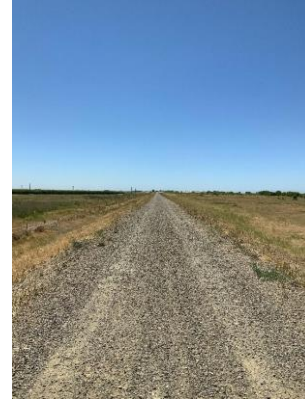
Photo 1 of 3 : UCIP_SP_2024_71030_104070.jpg

Comment Code					
Inspector Comment					
DS_ID:19717 FS_ID:71030 EP_NO: N/A Repair Type: Non-Urgent EVAL Issue: Crossing Status: Found UCIP Comments: 06/22/2021 The record remains Non-Urgent. Crossing appears to be in good condition. No permit was found authorizing this encroachment. CVFPB will need to review crossing to determine owner. The UCIP inspection was completed with GEI staff, H.Dunn. (P.Espinoza – GEI) 04/23/2014 Sediment buildup in pipe visible from landward side--recommend contacting owner to clear pipe. (W. Wylie - DWR UCIP) FIELD_STRUCT_DESC: 24-inch corrugated metal gravity drainage pipe (CMP) through the levee, 12.0 feet below the crown. Flap gate on the waterside (WS) end. Concrete headwall on each end. [Additional Reference(s): DWR Levee Log, 2002, (HLM 17.21). USACE San Joaquin O&M Manual, Unit No. 601, Part No. 1, 1967, Amended in 1978, Revised 20 June 1985, (HLM 17.20)]. FS Date: 6/22/2021

View from levee crown.

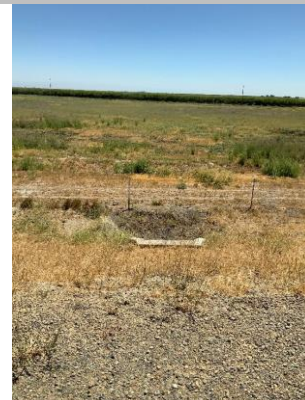
Photo 2 of 3 : UCIP_SP_2024_71030_104071.jpg

LS view of slope to toe from crown.

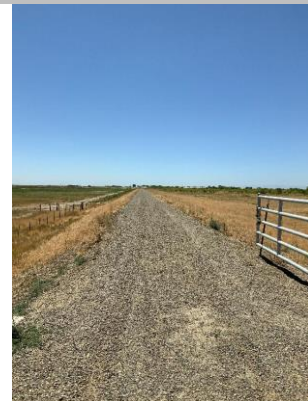
Photo 1 of 3 : UCIP_SP_2024_71031_104077.jpg

DS_ID:19743
FS_ID:71031
EP_NO: N/A
Repair Type: Non-Urgent
EVAL Issue:
Crossing Status: Found
UCIP Comments: 06/22/2021 The record remains Non-Urgent.
Crossing appears to be in good condition. No permit was found authorizing this encroachment. CVFPB will need to review crossing to determine owner. The UCIP inspection was completed with GEI staff, H.Dunn. (P.Espinoza – GEI) 04/23/2014 Sediment buildup in pipe visible from landward side--recommend contacting owner to clear pipe. (W. Wylie - DWR UCIP)
FIELD_STRUCT_DESC: 24-inch corrugated metal gravity drainage pipe (CMP) through the levee, 9.8 feet below the crown. Flap gate on the waterside (WS) end. Concrete headwall on each end. [Additional Reference(s): DWR Levee Log, 2002, (HLM 17.52). USACE San Joaquin O&M Manual, Unit No. 601, Part No. 1, 1967, Amended in 1978, Revised 20 June 1985, (HLM 17.52). DWR As-Built Specification No. 61-01, Sheet No. 58, 7 March 1961, (HLM 17.52)].

View from levee crown.

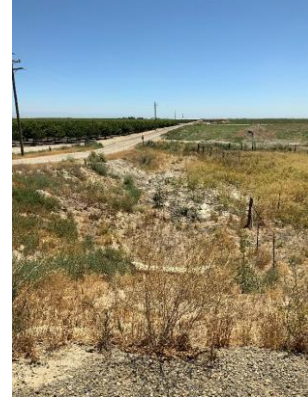
Photo 2 of 3 : UCIP_SP_2024_71031_104078.jpg

LS view of slope to toe from crown. Concrete headwall visible at toe.

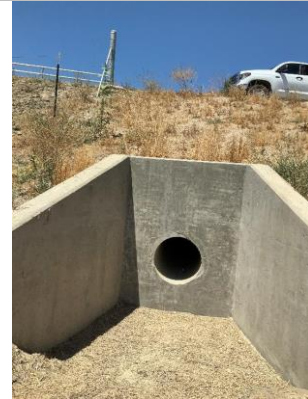
Photo 3 of 3 : UCIP_SP_2024_71031_104082.jpg

LS view from toe: concrete headwall and inlet. Slope visible in background.

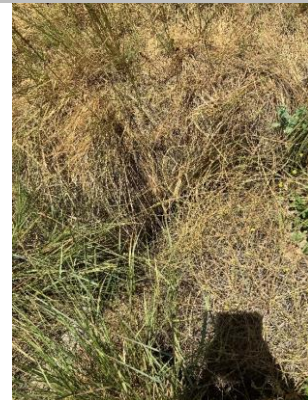
Photo 2 of 2 : UCIP_SP_2024_71033_104114.jpg

LS view: Closeup of headwall and inlet buried under dense vegetation at toe.

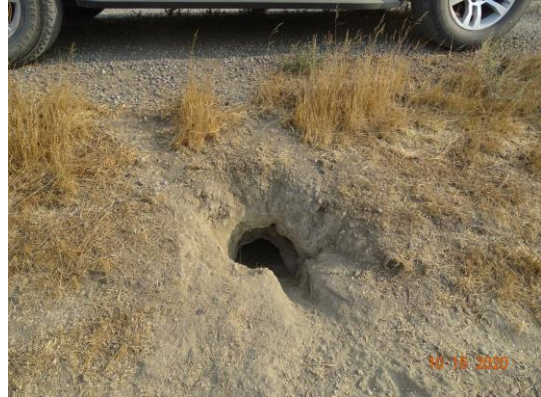
Photo 1 of 1 : SP_2024_NA0010_123_114_20240212_00015.jpg

LM Start	18.50	Rating **	A/W	Issue No.	114
LM End	18.50	Issue Type +	Ma	Location *	WS
Category	Earthen Levee			GPS Latitude/Longitude	
				Start	End
Item	Animal Control			37.115960°	37.115960°
				-120.577170°	-120.577170°
DWR ID	DWR_NA0010_05_f_2020_114				
Comment Code					
A3 : No rodents visible, but rodent burrows visible; need to backfill and compact or grout burrows.					
Inspector Comment					
Burrow appears to connect to hole in landside shoulder.

View of rodent burrow in the waterside shoulder. (Fall 2020)

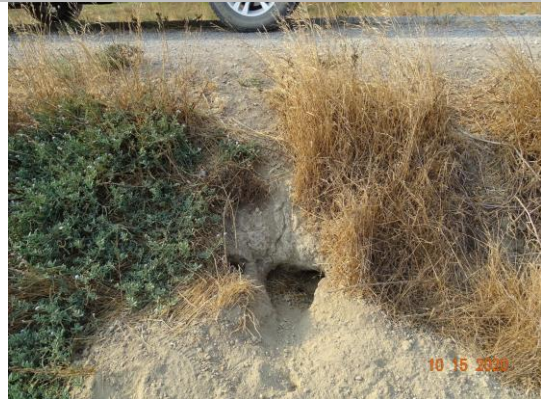
Photo 1 of 1 : SP_2024_NA0010_123_118_20240212_00017.jpg

LM Start	18.50	Rating **	A/W	Issue No.	118
LM End	18.50	Issue Type +	Ma	Location *	LS
Category	Earthen Levee			GPS Latitude/Longitude	
				Start	End
Item	Animal Control			37.115960°	37.115960°
				-120.577170°	-120.577170°
DWR ID	DWR_NA0010_05_f_2020_118				
Comment Code					
A3 : No rodents visible, but rodent burrows visible; need to backfill and compact or grout burrows.					
Inspector Comment					
Burrow appears to connect to hole in waterside shoulder.

Large rodent hole in the landside shoulder. (Fall 2020)

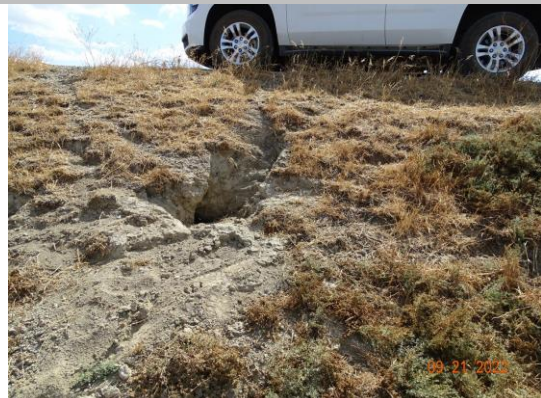
Photo 1 of 1 : SP_2024_NA0010_123_183_20240212_00063.jpg

LM Start	18.56	Rating **	A/W	Issue No.	183
LM End	18.56	Issue Type +	Ma	Location *	LS
Category	Earthen Levee			GPS Latitude/Longitude	
				Start	End
Item	Animal Control			37.115653°	37.115653°
				-120.576199°	-120.576199°
DWR ID	DWR_NA0010_05_f_2022_183				
Comment Code					
A3 : No rodents visible, but rodent burrows visible; need to backfill and compact or grout burrows.					
Inspector Comment

Large animal burrow on the landside slope. (Fall 2022)

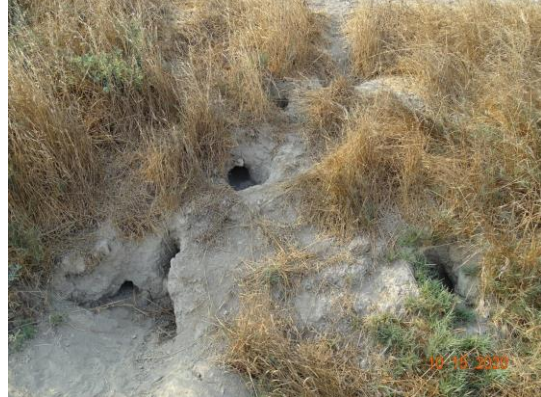
Photo 1 of 1 : SP_2024_NA0010_123_126_20240212_00023.jpg

LM Start	18.62	Rating **	U	Issue No.	126
LM End	18.62	Issue Type +	Ma	Location *	LS
Category	Earthen Levee			GPS Latitude/Longitude	
				Start	End
Item	Animal Control			37.115481°	37.115481°
				-120.575126°	-120.575126°
DWR ID	DWR_NA0010_05_f_2020_126				
Comment Code					
A3 : No rodents visible, but rodent burrows visible; need to backfill and compact or grout burrows.					
Inspector Comment

Several large rodent holes observed at this location. (Fall 2020)

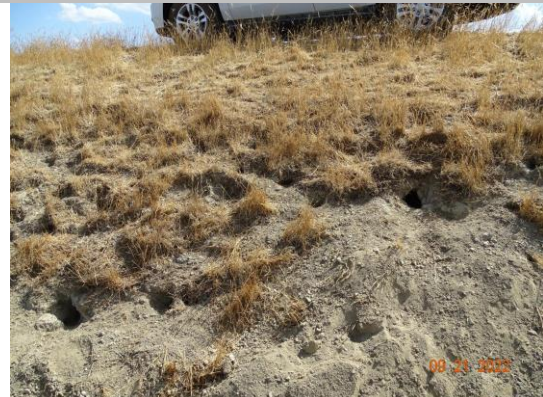
Photo 1 of 1 : SP_2024_NA0010_123_184_20240212_00064.jpg

LM Start	18.85	Rating **	M	Issue No.	184
LM End	19.27	Issue Type +	Ma	Location *	LS
Category	Earthen Levee			GPS Latitude/Longitude	
				Start	End
Item	Animal Control			37.115461 °	37.115289 °
				-120.570924 °	-120.563336 °
DWR ID	DWR_NA0010_05_f_2022_184				
Comment Code					
A3 : No rodents visible, but rodent burrows visible; need to backfill and compact or grout burrows.					
Inspector Comment

View of several rodent holes on the landside slope. (Fall 2022)

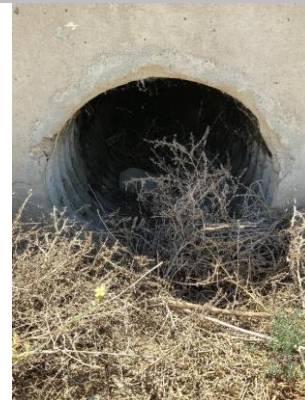
Photo 2 of 2 : UCIP_SP_2024_77864_104126.jpg

LS view: Closeup of inlet at toe.

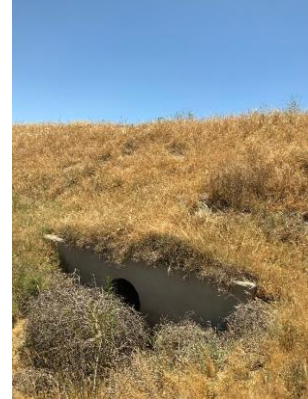
Photo 1 of 2 : UCIP_SP_2024_77869_104132.jpg

Comment Code						
Inspector Comment						
DS_ID:19776 FS_ID:77869 EP_NO: N/A Repair Type: Urgent EVAL Issue: 1, Pipe Integrity Crossing Status: Found UCIP Comments: 12/14/2022 Record updated from Non-Urgent to Urgent. DMP internal video inspection has found pipe integrity issues. LOF of crossing is between 5 and 6. Crossing will be monitored until funding becomes available to address the issues. (O.Yakimov - DWR UCIP) 06/22/2021 The record has been upgraded from No Action Needed to Non-Urgent. Some tumbleweed buildup around LS inlet, recommend removal. No permit was found authorizing this encroachment. CVFPB will need to review crossing to determine owner. The UCIP inspection was completed with GEI staff, P. Espinoza. (H. Dunn – GEI) FIELD_STRUCT_DESC: 24-inch corrugated metal gravity drainage pipe (CMP) through the levee, 10.3 feet below the crown. Flap gate on the waterside (WS) end. Concrete headwall on the landside (LS) end. Concrete U-shaped headwall on the WS end. [Additional Reference(s): DWR Levee Log, 2002, (HLM 19.15). USACE San Joaquin O&M Manual, Unit No. 601, Part No. 1, 1967, Amended in 1978, Revised 20 June 1985, (HLM 19.15). DWR As-Built Specification No. 64-01, Sheet No. 3, 6 November 1963, (HLM 19.15)]. FS Date: 6/22/2021 1:54:16 PM

LS view: Headwall and slope from toe.

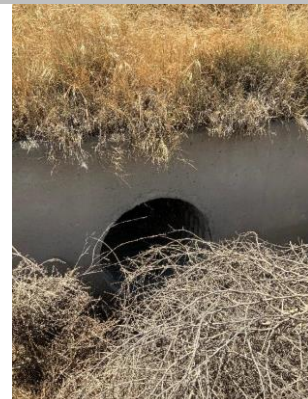
Photo 2 of 2 : UCIP_SP_2024_77869_104133.jpg

LS view: Closeup of inlet covered by tumbleweeds at toe.

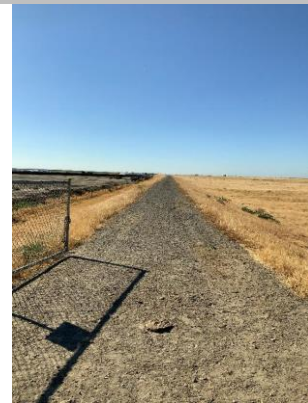
Photo 1 of 3 : UCIP_SP_2024_71039_104146.jpg

DS_ID:19778
 FS_ID:71039
 EP_NO: N/A
 Repair Type: Non-Urgent
 EVAL Issue:
 Crossing Status: Found
 UCIP Comments: 06/23/2021 The record remains Non-Urgent. DWR DMP internal inspection has not found pipe integrity issues. LOF of crossing is less or equal to 4.0. Recommend next video inspection in 5 years. No permit was found authorizing this encroachment. CVFPB will need to review crossing to determine owner. The UCIP inspection was completed with GEI staff, P. Espinoza. (H. Dunn – GEI) 04/23/2014
 Dense vegetation limits the inspector's visibility to identify signs of pipe failure (leaks) along the landward slope. Recommend removing vegetation along pipe alignment to conduct proper inspection of structure. Sediment buildup in pipe visible from landward side-- recommend contacting owner to clear pipe. (W. Wylie - DWR UCIP)
 FIELD_STRUCT_DESC: 24-inch corrugated metal gravity drainage pipe (CMP) through the levee, 9.7 feet below the crown. Flap gate on the waterside (WS) end. Concrete headwall on the landside (LS) end. Concrete U-shaped headwall on the WS end. [Additional Reference(s): DWR Levee Log, 2002, (HLM 19.50). USACE San Joaquin O&M Manual, Unit No. 601, Part No. 1, 1967, Amended in 1978, Revised 20 June 1985, (HLM 19.50). DWR As-Built Specification No. 64-01, Sheet No. 3, 6 November 1963, (HLM 19.50)].

Levee crown.

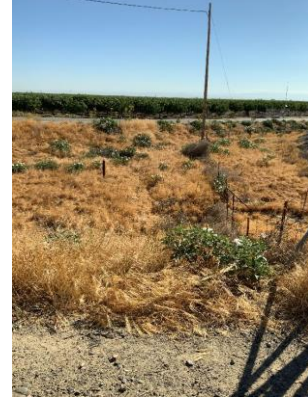
Photo 2 of 3 : UCIP_SP_2024_71039_104147.jpg

LS view: Toe from crown.

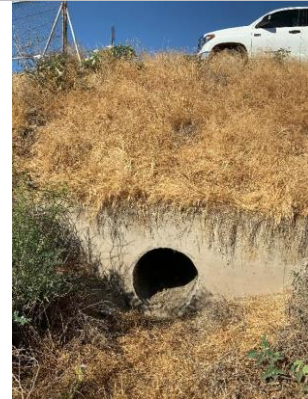
Photo 3 of 3 : UCIP_SP_2024_71039_104144.jpg

LS view: Headwall and slope at toe.

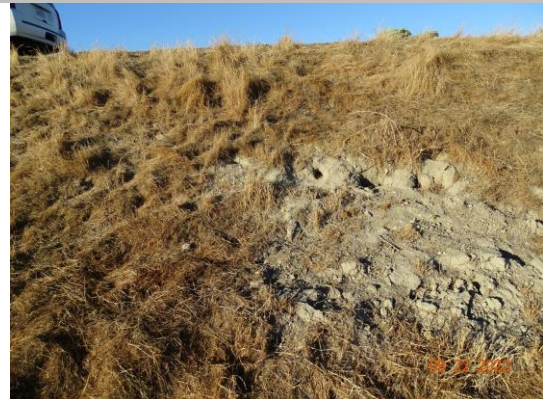
Photo 1 of 1 : SP_2024_NA0010_123_185_20240212_00065.jpg

LM Start	19.55	Rating **	M	Issue No.	185
LM End	19.55	Issue Type +	Ma	Location *	LS
Category	Earthen Levee			GPS Latitude/Longitude	
				Start	End
Item	Animal Control			37.112675 °	37.112675 °
				-120.559535 °	-120.559535 °
DWR ID	DWR_NA0010_05_f_2022_185				
Comment Code					
A3 : No rodents visible, but rodent burrows visible; need to backfill and compact or grout burrows.					
Inspector Comment

View of rodent burrows in the landside slope. (Fall 2022)

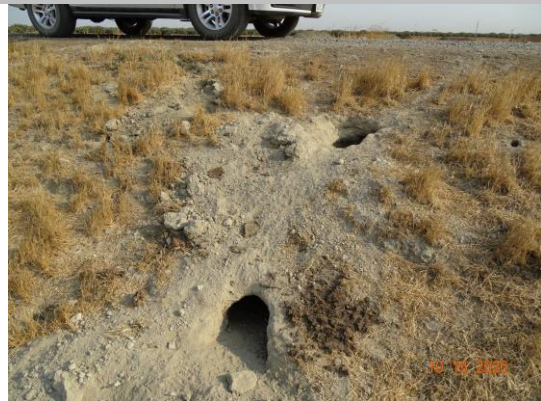
Photo 1 of 1 : SP_2024_NA0010_123_128_20240212_00024.jpg

LM Start	19.64	Rating **	U	Issue No.	128
LM End	19.64	Issue Type +	Ma	Location *	WS
Category	Earthen Levee			GPS Latitude/Longitude	
				Start	End
Item	Animal Control			37.111664°	37.111664°
				-120.558511°	-120.558511°
DWR ID	DWR_NA0010_05_f_2020_128				
Comment Code					
A3 : No rodents visible, but rodent burrows visible; need to backfill and compact or grout burrows.					
Inspector Comment

View of rodent activity on the waterside slope. (Fall 2020)

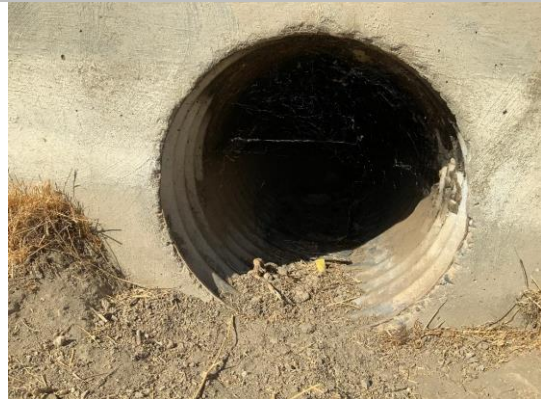
Photo 1 of 3 : UCIP_SP_2024_77907_104154.jpg

DS_ID:19779
FS_ID:77907
EP_NO: N/A
Repair Type: Non-Urgent
EVAL Issue:
Crossing Status: Found
UCIP Comments: 12/20/2022 Record updated from Urgent to Non-Urgent. Pipe has been CIPP-lined. LOF of crossing is less or equal to 4. Recommend next video inspection in 5 years. (O.Yakimov - DWR UCIP)
06/23/2021 The record has been upgraded from No Action Needed to Urgent. DWR DMP internal inspection has found pipe integrity issues. LOF of crossing is greater than or equal to 5 and less than 6. Crossing will be monitored until funding becomes available to address the issues. WS flapgate has holes in it. LS pipe inlet has some minor debris buildup. No permit was found authorizing this encroachment. CVFPB will need to review crossing to determine owner. The UCIP inspection was completed with GEI staff, P. Espinoza. (H. Dunn – GEI)
FIELD_STRUCT_DESC: 24-inch CIPP-lined corrugated metal gravity drainage pipe (CMP) through the levee, 10.3 feet below the crown. Flap gate on the waterside (WS) end. Concrete headwall on the landside (LS) end. Concrete U-shaped headwall on the WS end. [Additional Reference(s): DWR Levee Log, 2002, (HLM 19.83). USACE San Joaquin O&M Manual, Unit No. 601, Part No. 1, 1967, Amended in 1978, Revised 20 June 1985, (HLM 19.84). DWR As-Built Specification No. 64-01, Sheet No. 4, 6 November 1963, (HLM 19.84)].

LS view: Closeup of pipe inlet at toe.

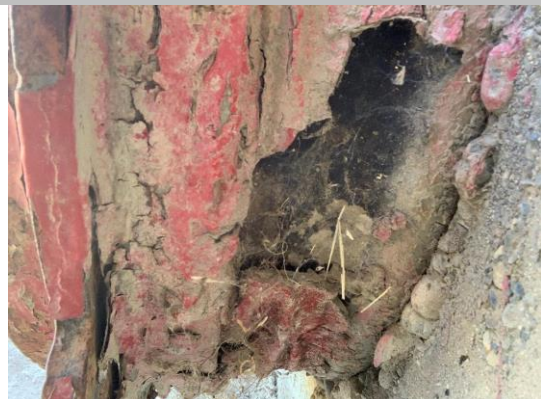
Photo 2 of 3 : UCIP_SP_2024_77907_104110.jpg

WS view: Closeup of deterioration of flapgate at toe.

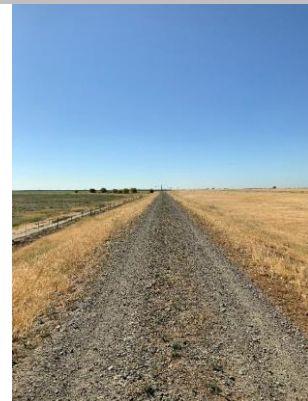
Photo 1 of 3 : UCIP_SP_2024_71041_104156.jpg

DS_ID:19780
FS_ID:71041
EP_NO: N/A
Repair Type: Non-Urgent
EVAL Issue:
Crossing Status: Found
UCIP Comments: 06/23/2021 The record has been upgraded from No Action Needed to Non-Urgent. DWR DMP internal inspection has not found pipe integrity issues. LOF of crossing is less or equal to 4.0. Recommend next video inspection in 5 years. No permit was found authorizing this encroachment. CVFPB will need to review crossing to determine owner. The UCIP inspection was completed with GEI staff, P. Espinoza. (H. Dunn – GEI)
FIELD_STRUCT_DESC: 36-inch corrugated metal gravity drainage pipe (CMP) through the levee, 9.8 feet below the crown. Flap gate on the waterside (WS) end. Concrete headwall on the landside (LS) end. Concrete U-shaped headwall on the WS end. [Additional Reference(s): DWR Levee Log, 2002, (HLM 19.92). USACE San Joaquin O&M Manual, Unit No. 601, Part No. 1, 1967, Amended in 1978, Revised 20 June 1985, (HLM 19.92). DWR As-Built Specification No. 64-01, Sheet No. 4, 6 November 1963, (HLM 19.92)].

Levee crown.

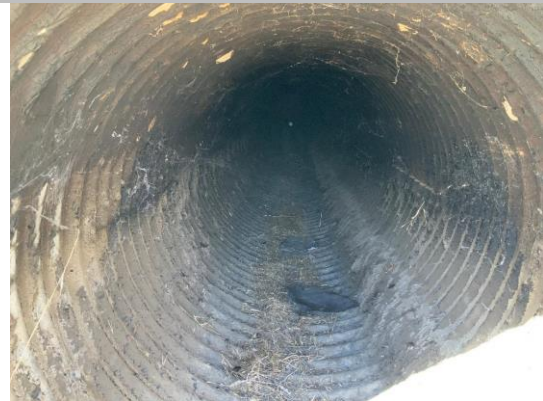
Photo 3 of 3 : UCIP_SP_2024_71041_104155.jpg

LS view: Inside pipe inlet at toe.

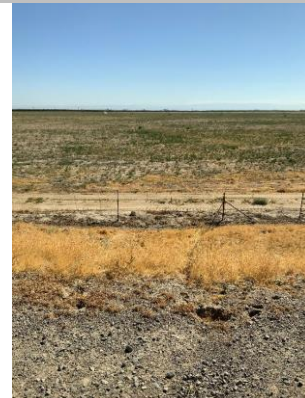
Photo 2 of 3 : UCIP_SP_2024_71042_104164.jpg

LS view: Toe from crown.
