Flood Control Project Maintenance
Levee Inspections
LMA District Cover Sheet

Lower San Joaquin Levee District

**Flood Control Project Maintenance
Levee Inspections
Unit Cover Sheet**

Levee Inspection Report By Mile - Spring 2024

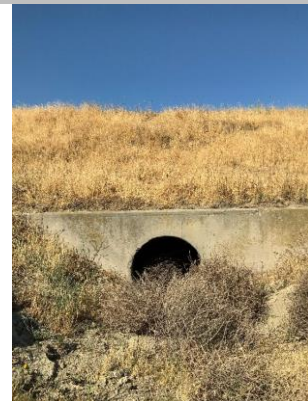
Photo 1 of 2 : UCIP_SP_2024_71043_104168.jpg

DS_ID:19783
FS_ID:71043
EP_NO: N/A
Repair Type: Non-Urgent
EVAL Issue: 11, Maintenance Compliance Issue
Crossing Status: Found
UCIP Comments: 06/23/2021 The record has been upgraded from No Action Needed to Non-Urgent. DWR DMP internal inspection has not found pipe integrity issues. LOF of crossing is less or equal to 4.0. Recommend next video inspection in 5 years. Limited inspection of LS pipe inlet due to tumbleweeds, recommend removal. No permit was found authorizing this encroachment. CVFPB will need to review crossing to determine owner. The UCIP inspection was completed with GEI staff, P. Espinoza. (H. Dunn – GEI)
FIELD_STRUCT_DESC: 36-inch corrugated metal gravity drainage pipe (CMP) through the levee, 10.6 feet below the crown. Flap gate on the waterside (WS) end. Concrete headwall on each end. [Additional Reference(s): DWR Levee Log, 2002, (HLM 20.18). USACE San Joaquin O&M Manual, Unit No. 601, Part No. 1, 1967, Amended in 1978, Revised 20 June 1985, (HLM 20.18). DWR As-Built Specification No. 64-01, Sheet No. 4, 6 November 1963, (HLM 20.18)].

LS view: Slope and headwall from toe.

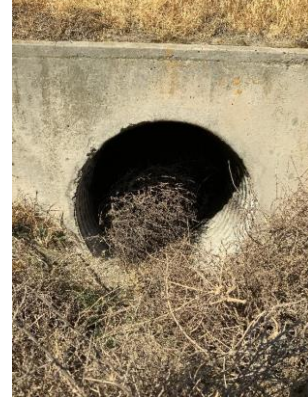
Photo 2 of 2 : UCIP_SP_2024_71043_104169.jpg

LS view: Closeup of pipe inlet at toe.

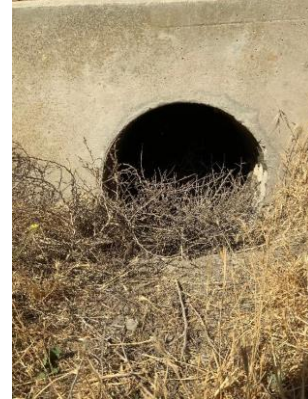
Photo 1 of 1 : UCIP_SP_2024_77908_104180.jpg

Comment Code						
Inspector Comment						
DS_ID:19784 FS_ID:77908 EP_NO: N/A Repair Type: Non-Urgent EVAL Issue: 11, Maintenance Compliance Issue Crossing Status: Found UCIP Comments: 12/20/2022 Record updated from Urgent to Non-Urgent. Pipe has been CIPP-lined. LOF of crossing is less or equal to 4. Recommend next video inspection in 5 years. (O.Yakimov - DWR UCIP) 06/23/2021 The record has been upgraded from Non-Urgent to Urgent. DWR DMP internal inspection has found pipe integrity issues. LOF of crossing is greater than or equal to 5 and less than 6. Crossing will be monitored until funding becomes available to address the issues. Some tumbleweed buildup at LS pipe inlet, recommend removal. No permit was found authorizing this encroachment. CVFPB will need to review crossing to determine owner. The UCIP inspection was completed with GEI staff, P. Espinoza. (H. Dunn – GEI)04/23/2014 Dense vegetation limits the inspector's visibility to identify signs of pipe failure (leaks) along the landward slope. Recommend removing vegetation along pipe alignment to conduct proper inspection of structure. (W. Wylie - DWR UCIP) FIELD_STRUCT_DESC: 24-inch CIPP-lined corrugated metal gravity drainage pipe (CMP) through the levee, 10.5 feet below the crown. Flap gate on the waterside (WS) end. Concrete headwall on the landside (LS) end. Concrete U-shaped headwall on the WS end. [Additional Reference(s): DWR Levee Log, 2002, (HLM 20.58). USACE San Joaquin O&M Manual, Unit No. 601, Part No. 1, 1967, Amended in 1978, Revised 20 June 1985, (HLM 20.59). DWR As-Built Specification No. 64-01, Sheet No. 4, 6 November 1963, (HLM 20.59)]. FS Date: 6/23/2021

LS view: Tumbleweeds in pipe inlet at toe.

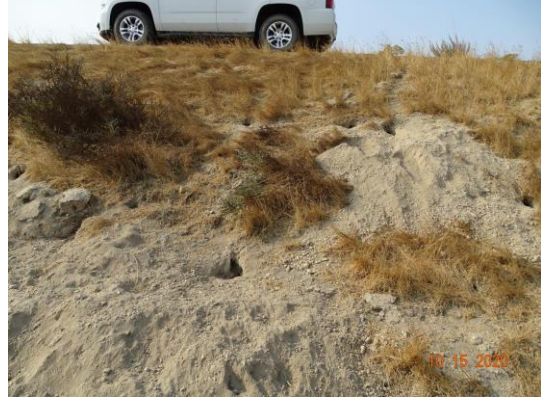
Photo 1 of 1 : SP_2024_NA0010_123_135_20240212_00029.jpg

LM Start	20.93	Rating **	M	Issue No.	135
LM End	20.93	Issue Type +	Ma	Location *	LS
Category	Earthen Levee			GPS Latitude/Longitude	
				Start	End
Item	Animal Control			37.097826°	37.097826°
				-120.543984°	-120.543984°
DWR ID	DWR_NA0010_05_f_2020_135				
Comment Code					
A3 : No rodents visible, but rodent burrows visible; need to backfill and compact or grout burrows.					
Inspector Comment

View of rodent burrow in the landside slope. (Fall 2020)

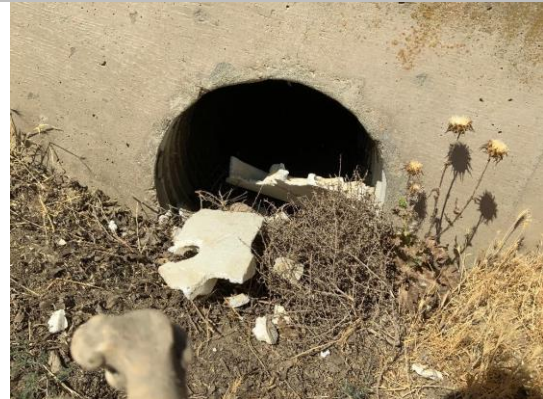
Photo 1 of 2 : UCIP_SP_2024_77909_104182.jpg

Comment Code						
Inspector Comment						
DS_ID:19785						
FS_ID:77909						
EP_NO: N/A						
Repair Type: Non-Urgent						
EVAL Issue: 11, Maintenance Compliance Issue						
Crossing Status: Found						
UCIP Comments: 12/20/2022 Record updated from Urgent to Non-Urgent. Pipe has been CIPP-lined. LOF of crossing is less or equal to 4. Recommend next video inspection in 5 years. (O.Yakimov - DWR UCIP)						
06/23/2021 The record is being upgraded from Non-Urgent to Urgent. DWR DMP internal inspection has found pipe integrity issues. LOF of crossing is greater than or equal to 5 and less than 6. Crossing will be monitored until funding becomes available to address the issues. Tumbleweed and debris covering LS pipe inlet, recommend removal. No permit was found authorizing this encroachment. CVFPB will need to review crossing to determine owner. The UCIP inspection was completed with GEI staff, P. Espinoza. (H. Dunn – GEI)04/23/2014 Dense vegetation limits the inspector's visibility to identify signs of pipe failure (leaks) along the landward slope. Recommend removing vegetation along pipe alignment to conduct proper inspection of structure. (W. Wylie - DWR UCIP)

LS view: Debris inside pipe inlet at toe.

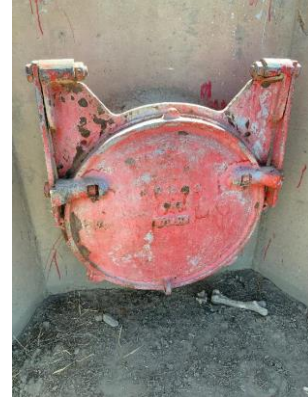
Photo 2 of 2 : UCIP_SP_2024_77912_104215.jpg

WS view: Closeup of flapgate at toe.

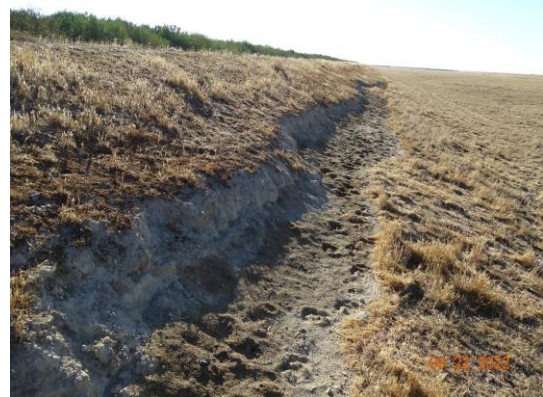
Photo 1 of 1 : SP_2024_NA0010_123_121_20240212_00019.jpg

LM Start	22.28	Rating **	M	Issue No.	121
LM End	22.35	Issue Type +	Ma	Location *	WS
Category	Earthen Levee			GPS Latitude/Longitude	
				Start	End
Item	Erosion / Livestock			37.083388°	37.082696°
				-120.528382°	-120.527620°
DWR ID	DWR_NA0010_05_f_2017_121				
Comment Code					
E4 : Repair the levee slope damaged by livestock and prevent large animal access.					
Inspector Comment					
Waterside slope damaged by animal traffic.

Looking southeast at the waterside slope. (Fall 2022)

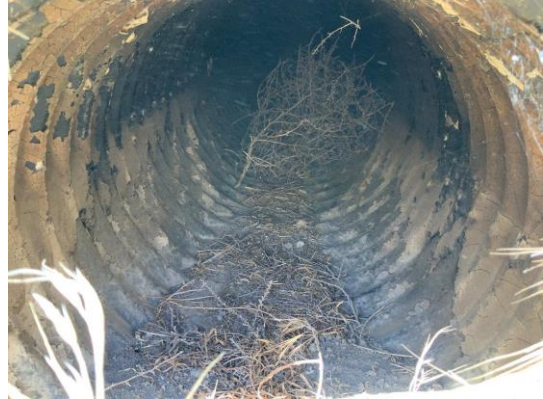
Photo 1 of 3 : UCIP_SP_2024_77914_104228.jpg

Comment Code						
Inspector Comment						
DS_ID:19791 FS_ID:77914 EP_NO: N/A Repair Type: Non-Urgent EVAL Issue: Crossing Status: Found UCIP Comments: 12/20/2022 Record updated from Urgent to Non-Urgent. Pipe has been CIPP-lined. LOF of crossing is less or equal to 4. Recommend next video inspection in 5 years. (O.Yakimov - DWR UCIP) 06/23/2021 The record has been upgraded from Non-Urgent to Urgent. DWR DMP internal inspection has found pipe integrity issues. LOF of crossing is greater than or equal to 5 and less than 6. Crossing will be monitored until funding becomes available to address the issues. Deterioration of the underside of the WS flapgate. No permit was found authorizing this encroachment. CVFPB will need to review crossing to determine owner. The UCIP inspection was completed with GEI staff, P. Espinoza. (H. Dunn – GEI)04/23/2014 Dense vegetation limits the inspector's visibility to identify signs of pipe failure (leaks) along the landward slope. Recommend removing vegetation along pipe alignment to conduct proper inspection of structure. Sediment buildup in pipe visible from landward side--recommend contacting owner to clear pipe. (W. Wylie - DWR UCIP) FIELD_STRUCT_DESC: 24-inch CIPP-lined corrugated metal gravity drainage pipe (CMP) through the levee, 12.2 feet below the crown. Flap gate on the waterside (WS) end. Concrete headwall on the landside (LS) end. Concrete U-shaped headwall on the WS end. [Additional Reference(s): DWR Levee Log, 2002, (HLM 22.79). USACE San Joaquin O&M Manual, Unit No. 601, Part No. 1, 1967, Amended in 1978, Revised 20 June 1985, (HLM 22.79). DWR As-Built Specification No. 64-01, Sheet No. 6, 6 November 1963, (HLM 22.79)]. FS Date: 6/23/2021 10:31:02 AM

LS view: Inside pipe inlet at toe.

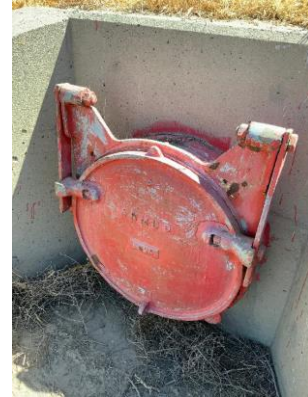
Photo 2 of 3 : UCIP_SP_2024_77914_104224.jpg

WS view: Closeup of flapgate at toe.

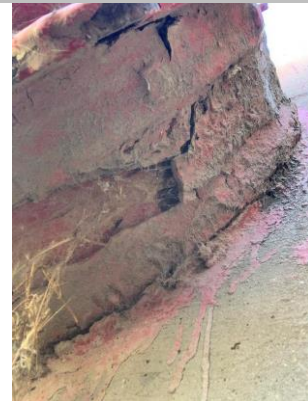
Photo 3 of 3 : UCIP_SP_2024_77914_104225.jpg

WS view: Deterioration and holes underneath flapgate at toe.

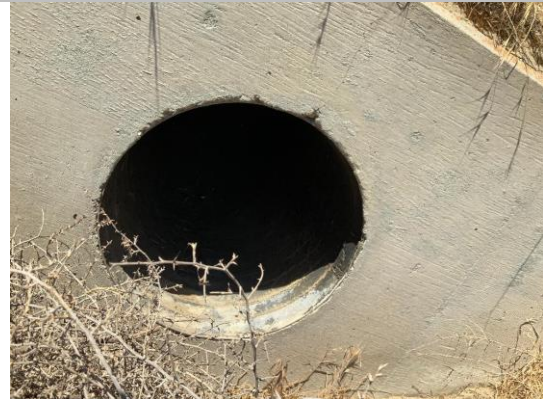
Photo 1 of 3 : UCIP_SP_2024_77915_104234.jpg

Comment Code						
Inspector Comment						
DS_ID:19792 FS_ID:77915 EP_NO: N/A Repair Type: Non-Urgent EVAL Issue: Crossing Status: Found UCIP Comments: 12/20/2022 Record updated from Urgent to Non-Urgent. Pipe has been CIPP lined. LOF of crossing is less or equal to 4. Recommend next video inspection in 5 years. (O.Yakimov - DWR UCIP) 06/23/2021 The record has been upgraded from Non-Urgent to Urgent. DWR DMP internal inspection has found pipe integrity issues. LOF of crossing is greater than or equal to 5 and less than 6. Crossing will be monitored until funding becomes available to address the issues. Deterioration of the underside of the WS flapgate. No permit was found authorizing this encroachment. CVFPB will need to review crossing to determine owner. The UCIP inspection was completed with GEI staff, P. Espinoza. (H. Dunn – GEI)04/23/2014 Dense vegetation limits the inspector's visibility to identify signs of pipe failure (leaks) along the landward slope. Recommend removing vegetation along pipe alignment to conduct proper inspection of structure. (W. Wylie - DWR UCIP) FIELD_STRUCT_DESC: 24-inch CIPP-lined corrugated metal gravity drainage pipe (CMP) through the levee, 11.1 feet below the crown. Flap gate on the waterside (WS) end. Concrete headwall on the landside (LS) end. Concrete U-shaped headwall on the WS end. [Additional Reference(s): DWR Levee Log, 2002, (HLM 22.93). USACE San Joaquin O&M Manual, Unit No. 601, Part No. 1, 1967, Amended in 1978, Revised 20 June 1985, (HLM 22.94). DWR As-Built Specification No. 64-01, Sheet No. 6, 6 November 1963, (HLM 22.94)]. FS Date: 6/23/2021 10:31:37 AM

LS view: Closeup of pipe inlet at toe.

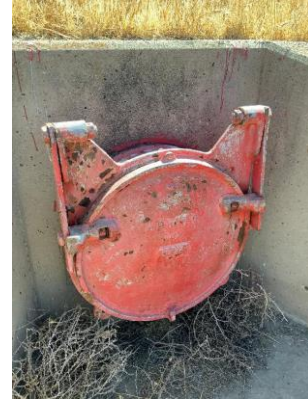
Photo 2 of 3 : UCIP_SP_2024_77915_104239.jpg

WS view: Closeup of flapgate at toe.

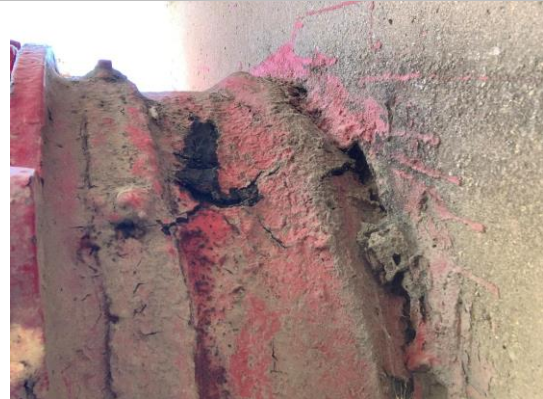
Photo 3 of 3 : UCIP_SP_2024_77915_104232.jpg

WS view: Some deterioration of flapgate at toe.

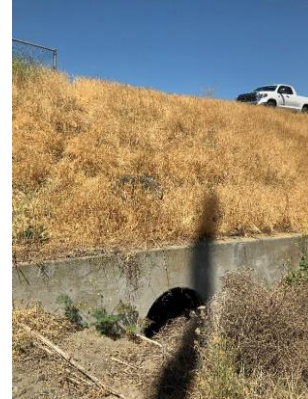
Photo 1 of 2 : UCIP_SP_2024_71053_104333.jpg

Comment Code						
Inspector Comment						
DS_ID:19793 FS_ID:71053 EP_NO: N/A Repair Type: Non-Urgent EVAL Issue: 11, Maintenance Compliance Issue Crossing Status: Found UCIP Comments: 06/23/2021 The record remains Non-Urgent. DWR DMP internal inspection has not found pipe integrity issues. LOF of crossing is less or equal to 4.0. Recommend next video inspection in 5 years. Some vegetation covering LS inlet and WS flapgate, recommend removal on both ends. No permit was found authorizing this encroachment. CVFPB will need to review crossing to determine owner. The UCIP inspection was completed with GEI staff, P. Espinoza. (H. Dunn – GEI) 04/23/2014 Debris blocking closure of outlet. Dense vegetation limits the inspector's visibility to identify signs of pipe failure (leaks) along the waterward and landward slopes. Recommend removing vegetation along pipe alignment to conduct proper inspection of structure. (W. Wylie - DWR UCIP) FIELD_STRUCT_DESC: 24-inch corrugated metal gravity drainage pipe (CMP) through the levee, 11.5 feet below the crown. Flap gate on the waterside (WS) end. Concrete headwall on the landside (LS) end. Concrete U-shaped headwall on the WS end. [Additional Reference(s): DWR Levee Log, 2002, (HLM 23.06)]. FS Date: 6/23/2021

LS view: Slope and headwall from toe.

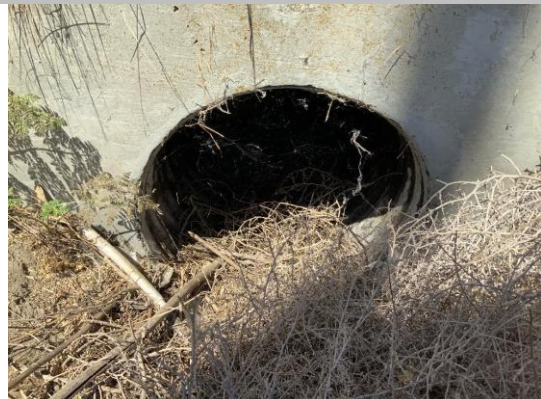
Photo 2 of 2 : UCIP_SP_2024_71053_104334.jpg

LS view: Closeup of inlet at toe.

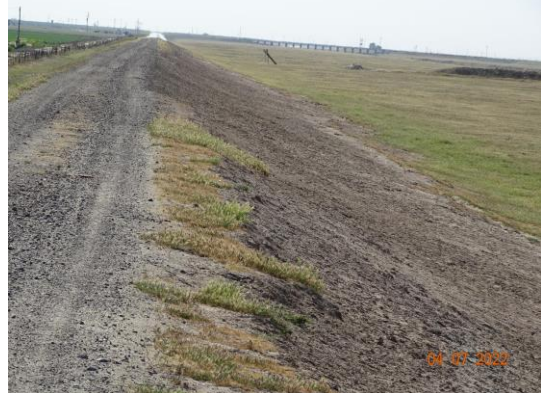
Photo 1 of 1 : SP_2024_NA0010_123_160_20240212_00047.jpg

LM Start	23.24	Rating **	M	Issue No.	160
LM End	23.68	Issue Type +	Ma	Location *	WS
Category	Earthen Levee			GPS Latitude/Longitude	
				Start	End
Item	Erosion / Livestock			37.073064°	37.068260°
				-120.516771°	-120.511583°
DWR ID	DWR_NA0010_05_f _ 2018_160				
Comment Code					
E4 : Repair the levee slope damaged by livestock and prevent large animal access.					
Inspector Comment					
There is slope damage caused by livestock on waterside.

Slope damage cause by livestock foot traffic. (Spring 2022)

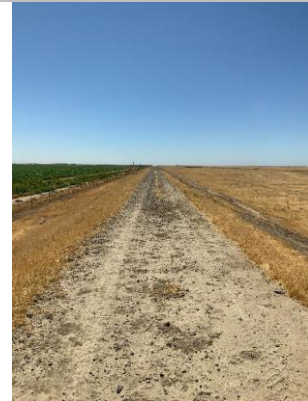
Photo 1 of 3 : UCIP_SP_2024_71054_104342.jpg

Comment Code						
Inspector Comment						
DS_ID:19794 FS_ID:71054 EP_NO: N/A Repair Type: Non-Urgent EVAL Issue: Crossing Status: Found UCIP Comments: 06/23/2021 The record has been upgraded from No Action Needed to Non-Urgent. DWR DMP internal inspection has not found pipe integrity issues. LOF of crossing is less or equal to 4.0. Recommend next video inspection in 5 years. No permit was found authorizing this encroachment. CVFPB will need to review crossing to determine owner. The UCIP inspection was completed with GEI staff, P. Espinoza. (H. Dunn – GEI) FIELD_STRUCT_DESC: 30-inch corrugated metal gravity drainage pipe (CMP) through the levee, 11.6 feet below the crown. Flap gate on the waterside (WS) end. Concrete headwall on the landside (LS) end. Concrete U-shaped headwall on the WS end. [Additional Reference(s): DWR Levee Log, 2002, (HLM 23.14). USACE San Joaquin O&M Manual, Unit No. 601, Part No. 1, 1967, Amended in 1978, Revised 20 June 1985, (HLM 23.15). DWR As-Built Specification No. 64-01, Sheet No. 6, 6 November 1963, (HLM 23.15)]. FS Date: 6/23/2021

Levee crown.

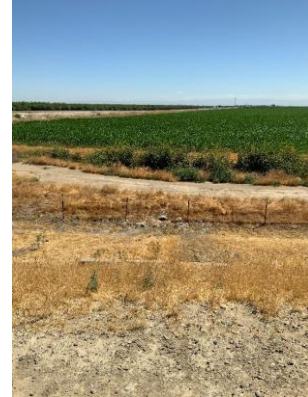
Photo 2 of 3 : UCIP_SP_2024_71054_104343.jpg

LS view: Toe from crown.

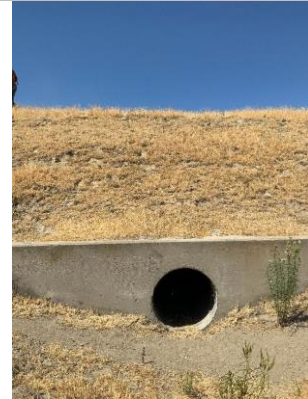
Photo 3 of 3 : UCIP_SP_2024_71054_104345.jpg

LS view: Slope and headwall from toe.

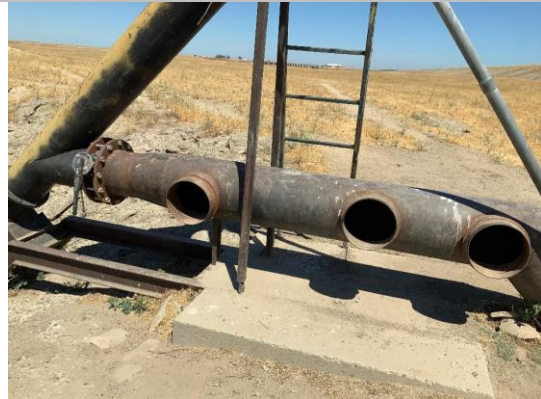
Photo 1 of 2 : UCIP_SP_2024_71055_104368.jpg

DS_ID:19795
 FS_ID:71055
 EP_NO: 13829
 Repair Type: Urgent
 EVAL Issue: 3a, Flood Risk
 Crossing Status: Found
 UCIP Comments: 06/23/2021 The record has been upgraded from No Action Needed to Urgent. Appears abandoned, WS pipe is missing parts as there are open holes without flapgates that would potentially allow water through, see photos. Open on both ends. Confirm with owner on the status of this pipe. The UCIP inspection was completed with GEI staff, P. Espinoza. (H. Dunn – GEI)
 FIELD_STRUCT_DESC: 1 of 2: 16-inch coated steel irrigation discharge pipe through the levee, 4.0 feet below the crown. Steel cutoff wall around the pipe at the center of the levee. Slant pump off the waterside (WS) toe. Siphon breaker in a 10-inch steel pipe riser unit on the landside (LS) shoulder. A preexisting ditch runs from the WS toe to the channel. Rock revetment on the cut slopes of the inlet channel. (Pump and 16-inch pipe authorized under Permit No. 13829, 1984 - John H. Sorenson, Inc.). [Additional Reference(s): DWR Levee Log, 2002, (HLM 23.51)].

WS view: Closeup of pipe with missing valves or covers, 1 of 2 photos.

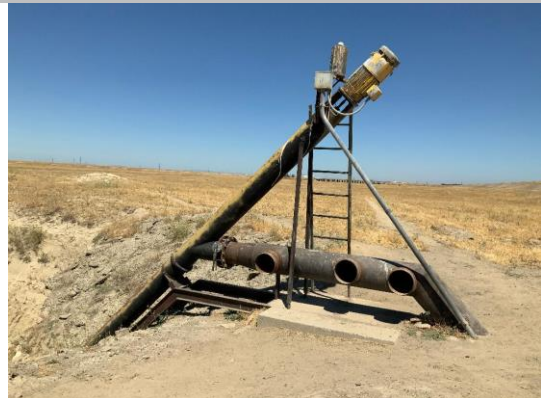
Photo 2 of 2 : UCIP_SP_2024_71055_104366.jpg

WS view: Pump and pipe off the toe, 2 of 2 photos.

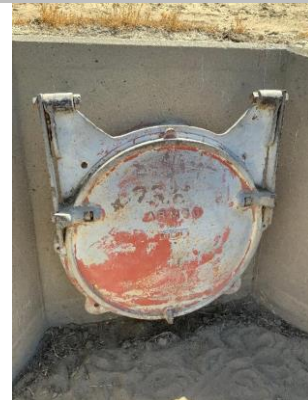
Photo 2 of 2 : UCIP_SP_2024_77916_104383.jpg

WS view: Closeup of flapgate at toe.

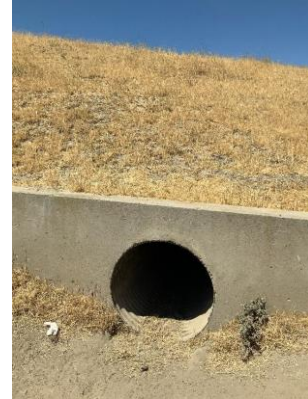
Photo 1 of 3 : UCIP_SP_2024_77917_104384.jpg

Comment Code						
Inspector Comment						
DS_ID:19797 FS_ID:77917 EP_NO: N/A Repair Type: Non-Urgent EVAL Issue: Crossing Status: Found UCIP Comments: 12/20/2022 Record updated from Urgent to Non-Urgent. Pipe has been CIPP lined. LOF of crossing is less or equal to 4. Recommend next video inspection in 5 years. (O.Yakimov - DWR UCIP) 06/23/2021 The record has been upgraded from Non-Urgent to Urgent. DWR DMP internal inspection has found pipe integrity issues. LOF of crossing is greater than or equal to 5 and less than 6. Crossing will be monitored until funding becomes available to address the issues. Small hole seen in the front of the WS flapgate. No permit was found authorizing this encroachment. CVFPB will need to review crossing to determine owner. The UCIP inspection was completed with GEI staff, P. Espinoza. (H. Dunn – GEI)03/25/2014 Minor sediment/debris buildup in pipe visible from landward side--recommend contacting owner to clear pipe. (W. Wylie - DWR UCIP) FIELD_STRUCT_DESC: 36-inch CIPP-lined corrugated metal gravity drainage pipe (CMP) through the levee, 12.1 feet below the crown. Flap gate on the waterside (WS) end. Concrete headwall on the landside (LS) end. Concrete U-shaped headwall on the WS end. [Additional Reference(s): DWR Levee Log, 2002, (HLM 23.92). USACE San Joaquin O&M Manual, Unit No. 601, Part No. 1, 1967, Amended in 1978, Revised 20 June 1985, (HLM 23.85). DWR As-Built Specification No. 64-01, Sheet No. 7, 6 November 1963, (HLM 23.85)]. FS Date: 6/23/2021 10:38:30 AM

LS view: Slope and headwall from toe.

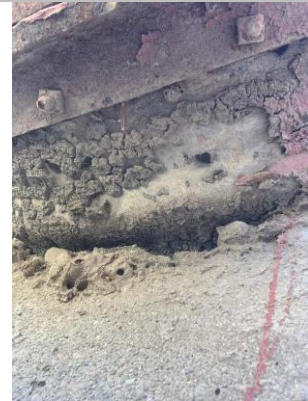
Photo 2 of 3 : UCIP_SP_2024_77918_104398.jpg

WS view: Closeup of hole under flapgate at toe, 1 of 2 photos.

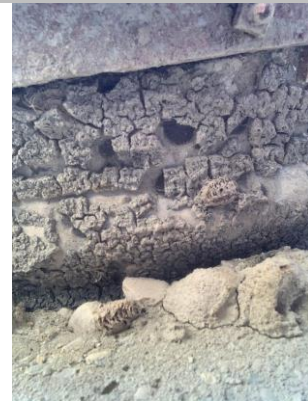
Photo 3 of 3 : UCIP_SP_2024_77918_104399.jpg

WS view: Closeup of hole under flapgate at toe, 2 of 2 photos.

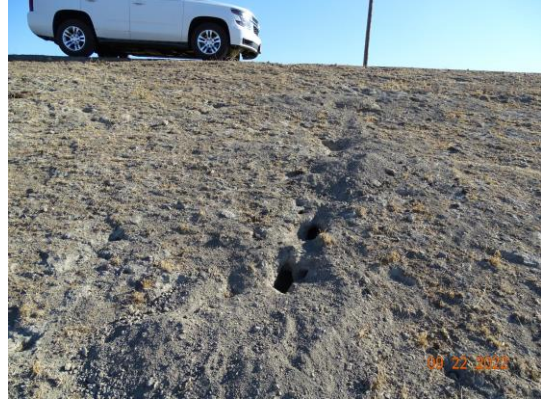
Photo 1 of 1 : SP_2024_NA0010_123_188_20240212_00067.jpg

LM Start	24.79	Rating **	M	Issue No.	188
LM End	24.79	Issue Type +	Ma	Location *	WS
Category	Earthen Levee			GPS Latitude/Longitude	
				Start	End
Item	Animal Control			37.056122°	37.056122°
				-120.498432°	-120.498432°
DWR ID	DWR_NA0010_05_f_2022_188				
Comment Code					
A3 : No rodents visible, but rodent burrows visible; need to backfill and compact or grout burrows.					
Inspector Comment

Several rodent burrows observed on the waterside slope. (Fall 2022)

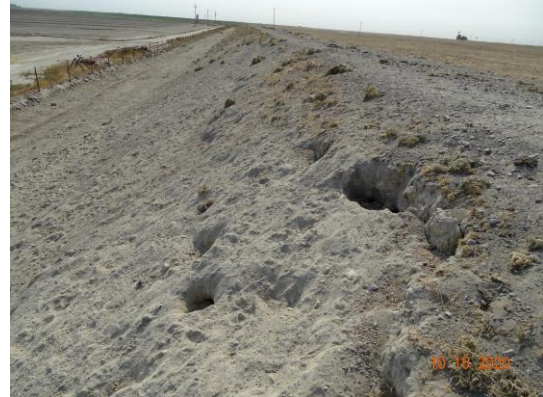
Photo 1 of 1 : SP_2024_NA0010_123_123_20240212_00020.jpg

LM Start	25.09	Rating **	A/W	Issue No.	123
LM End	25.09	Issue Type +	Ma	Location *	LS
Category	Earthen Levee			GPS Latitude/Longitude	
				Start	End
Item	Animal Control			37.053103°	37.053103°
				-120.494651°	-120.494651°
DWR ID	DWR_NA0010_05_f_2017_123				
Comment Code					
A1 : Exterminate rodents and backfill and compact or grout burrows.					
Inspector Comment

View of the landside slope looking upstream. (Fall 2020)

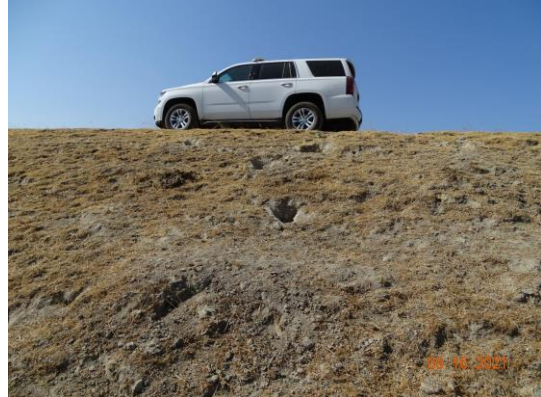
Photo 1 of 1 : SP_2024_NA0010_123_167_20240212_00052.jpg

LM Start	25.46	Rating **	A/W	Issue No.	167
LM End	25.52	Issue Type +	Ma	Location *	LS
Category	Earthen Levee			GPS Latitude/Longitude	
				Start	End
Item	Animal Control			37.049218°	37.048502°
				-120.489883°	-120.489257°
DWR ID	DWR_NA0010_05_f_2021_167				
Comment Code					
A3 : No rodents visible, but rodent burrows visible; need to backfill and compact or grout burrows.					
Inspector Comment

Multiple rodent holes observed on the landside slope. (Fall 2021)

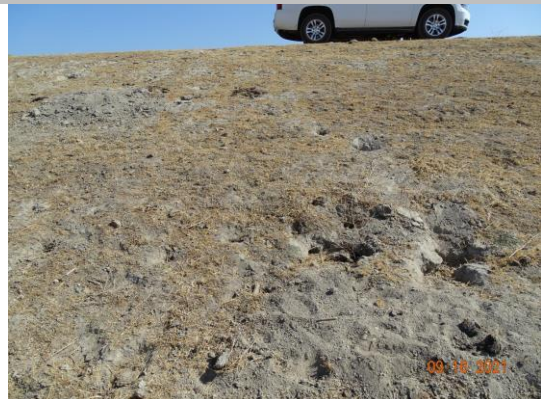
Photo 1 of 1 : SP_2024_NA0010_123_168_20240212_00053.jpg

LM Start	25.46	Rating **	A/W	Issue No.	168
LM End	25.46	Issue Type +	Ma	Location *	WS
Category	Earthen Levee			GPS Latitude/Longitude	
				Start	End
Item	Animal Control			37.049217°	37.049217°
				-120.489881°	-120.489881°
DWR ID	DWR_NA0010_05_f_2021_168				
Comment Code					
A3 : No rodents visible, but rodent burrows visible; need to backfill and compact or grout burrows.					
Inspector Comment

View of rodent burrows on the waterside slope. (Fall 2021)

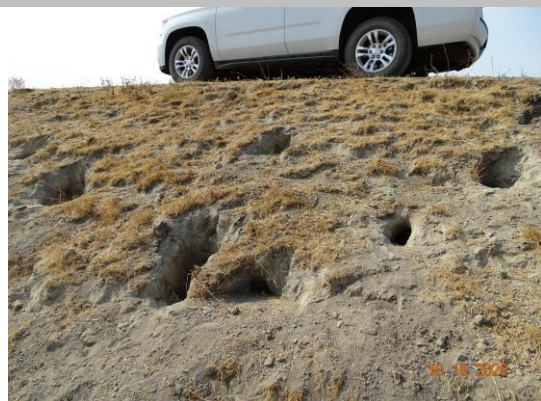
Photo 1 of 1 : SP_2024_NA0010_123_148_20240212_00037.jpg

LM Start	25.58	Rating **	U	Issue No.	148
LM End	25.60	Issue Type +	Ma	Location *	LS
Category	Earthen Levee			GPS Latitude/Longitude	
				Start	End
Item	Animal Control			37.047827°	37.047551°
				-120.488738°	-120.488527°
DWR ID	DWR_NA0010_05_f_2020_148				
Comment Code					
A3 : No rodents visible, but rodent burrows visible; need to backfill and compact or grout burrows.					
Inspector Comment

View of burrows in the landside. (Fall 2020)

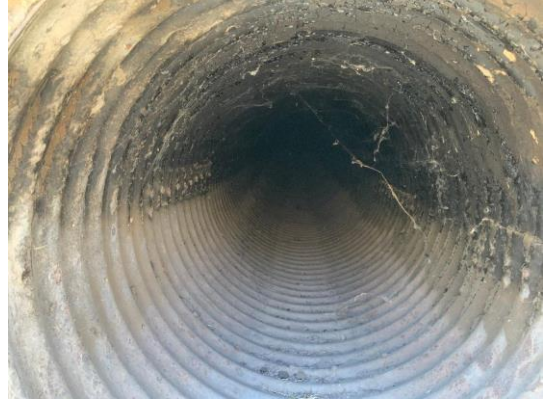
Photo 2 of 3 : UCIP_SP_2024_77919_104430.jpg

Comment Code						
Inspector Comment						
DS_ID:19804						
FS_ID:77919						
EP_NO: N/A						
Repair Type: Non-Urgent						
EVAL Issue:						
Crossing Status: Found						
UCIP Comments: 12/20/2022 Record updated from Urgent to Non-Urgent. Pipe has been CIPP lined. LOF of crossing is less or equal to 4. Recommend next video inspection in 5 years. (O.Yakimov - DWR UCIP)						
06/23/2021 The record has been upgraded from Non-Urgent to Urgent. DWR DMP internal inspection has found pipe integrity issues. LOF of crossing is greater than or equal to 5 and less than 6. Crossing will be monitored until funding becomes available to address the issues. No permit was found authorizing this encroachment. CVFPB will need to review crossing to determine owner. The UCIP inspection was completed with GEI staff, P. Espinoza. (H. Dunn – GEI)03/25/2014 Dense vegetation limits the inspector's visibility to identify signs of pipe failure (leaks) along the landward slope. Recommend removing vegetation along pipe alignment to conduct proper inspection of structure. Sediment buildup in pipe visible from landward side--recommend contacting owner to clear pipe. (W. Wylie - DWR UCIP) FIELD_STRUCT_DESC: 30-inch CIPP-lined corrugated metal gravity drainage pipe (CMP) through the levee, 12.0 feet below the crown. Flap gate on the waterside (WS) end. Concrete headwall on the landside (LS) end. Concrete U-shaped headwall on the WS end. [Additional Reference(s): DWR Levee Log, 2002, (HLM 25.51). USACE San Joaquin O&M Manual, Unit No. 601, Part No. 1, 1967, Amended in 1978, Revised 20 June 1985, (HLM 25.51). DWR As-Built Specification No. 64-01, Sheet No. 8, 6 November 1963, (HLM 25.51)].

LS view: Inside pipe inlet at toe.

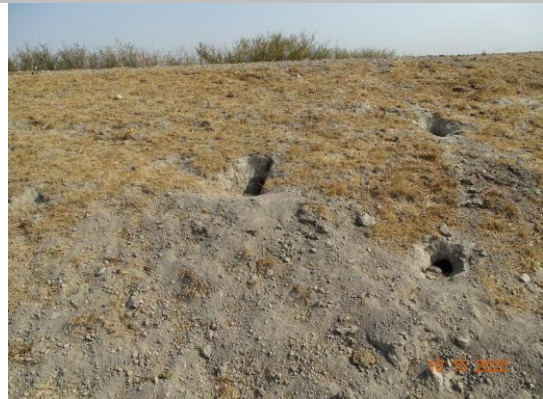
Photo 1 of 1 : SP_2024_NA0010_123_124_20240212_00021.jpg

LM Start	25.61	Rating **	M	Issue No.	124
LM End	25.61	Issue Type +	Ma	Location *	WS
Category	Earthen Levee			GPS Latitude/Longitude	
				Start	End
Item	Animal Control			37.047416°	37.047416°
				-120.488411°	-120.488411°
DWR ID	DWR_NA0010_05_f_2017_124				
Comment Code					
A1 : Exterminate rodents and backfill and compact or grout burrows.					
Inspector Comment

Looking east at the waterside slope. (Fall 2020)

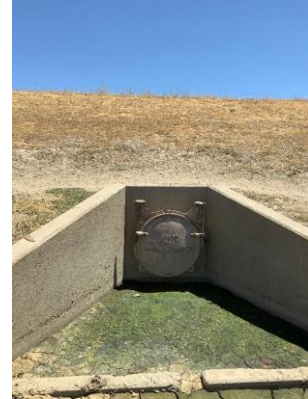
Photo 2 of 2 : UCIP_SP_2024_77920_104439.jpg

Comment Code						
Inspector Comment						
DS_ID:19805 FS_ID:77920 EP_NO: N/A Repair Type: Non-Urgent EVAL Issue: Crossing Status: Found UCIP Comments: 12/20/2022 Record updated from Urgent to Non-Urgent. Pipe has been CIPP lined. LOF of crossing is less or equal to 4. Recommend next video inspection in 5 years. (O.Yakimov - DWR UCIP) 06/23/2021 The record has been upgraded from Non-Urgent to Urgent. DWR DMP internal inspection has found pipe integrity issues. LOF of crossing is greater than or equal to 5 and less than 6. Crossing will be monitored until funding becomes available to address the issues. No permit was found authorizing this encroachment. CVFPB will need to review crossing to determine owner. The UCIP inspection was completed with GEI staff, P. Espinoza. (H. Dunn – GEI)03/25/2014 Sediment buildup in pipe visible from landward side--recommend contacting owner to clear pipe. (W. Wylie - DWR UCIP) FIELD_STRUCT_DESC: 30-inch CIPP-lined corrugated metal gravity drainage pipe (CMP) through the levee, 12.1 feet below the crown. Flap gate on the waterside (WS) end. Concrete headwall on the landside (LS) end. Concrete U-shaped headwall on the WS end. [Additional Reference(s): DWR Levee Log, 2002, (HLM 25.53). USACE San Joaquin O&M Manual, Unit No. 601, Part No. 1, 1967, Amended in 1978, Revised 20 June 1985, (HLM 25.53). DWR As-Built Specification No. 64-01, Sheet No. 8, 6 November 1963, (HLM 25.53)]. FS Date: 6/23/2021 10:40:17 AM

WS view: Slope, headwall, and flapgate from toe.

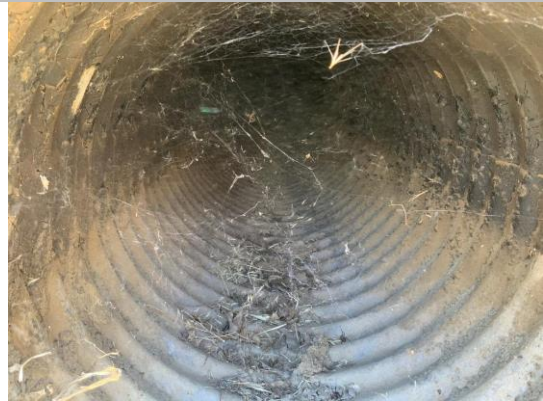
Photo 2 of 3 : UCIP_SP_2024_77921_104449.jpg

LS view: Inside pipe inlet at toe.

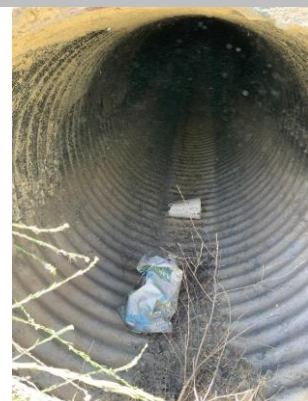
Photo 2 of 3 : UCIP_SP_2024_77930_104460.jpg

LS view: Inside of inlet at toe.

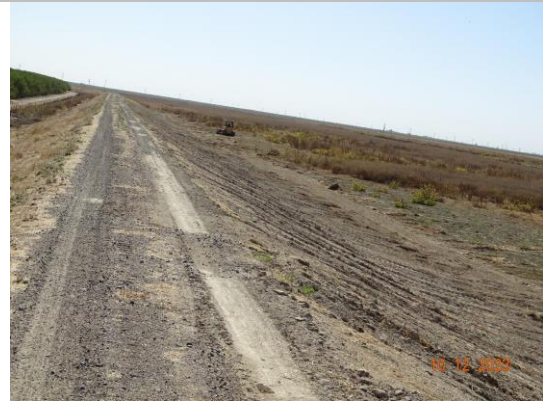
Photo 1 of 1 : SP_2024_NA0010_123_169_20240212_00054.jpg

LM Start	26.59	Rating **	A/W	Issue No.	169
LM End	26.69	Issue Type +	Ma	Location *	WS
Category	Earthen Levee			GPS Latitude/Longitude	
				Start	End
Item	Erosion / Livestock			37.035301°	37.034140°
				-120.479144°	-120.478076°
DWR ID	DWR_NA0010_05_f_2021_169				
Comment Code					
E4 : Repair the levee slope damaged by livestock and prevent large animal access.					
Inspector Comment					
Damage to the slope has been repaired. Monitor for potential settlement.

View of repaired waterside slope. (Fall 2023)

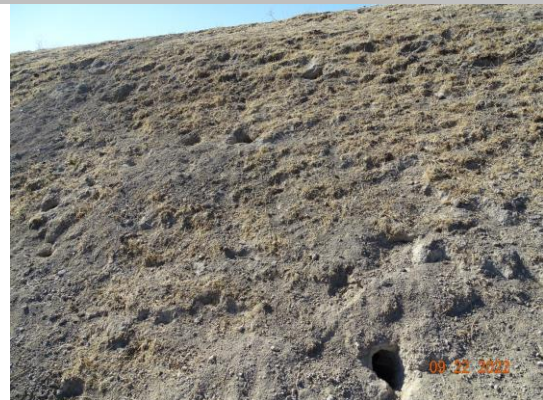
Photo 1 of 1 : SP_2024_NA0010_123_191_20240212_00070.jpg

LM Start	26.85	Rating **	M	Issue No.	191
LM End	26.92	Issue Type +	Ma	Location *	LS
Category	Earthen Levee			GPS Latitude/Longitude	
				Start	End
Item	Animal Control			37.032891°	37.032685°
				-120.475608°	-120.474378°
DWR ID	DWR_NA0010_05_f_2022_191				
Comment Code					
A3 : No rodents visible, but rodent burrows visible; need to backfill and compact or grout burrows.					
Inspector Comment

View of rodent burrows in the landside slope. (Fall 2022)

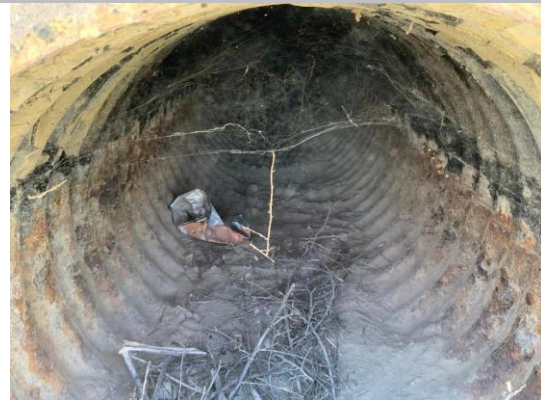
Photo 2 of 3 : UCIP_SP_2024_77922_104464.jpg

LS view: Inside of pipe inlet at toe.

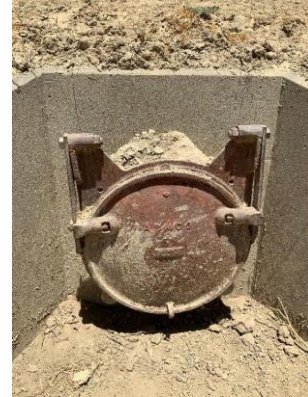
Photo 3 of 3 : UCIP_SP_2024_77922_104466.jpg

WS view: Closeup of flapgate at toe.

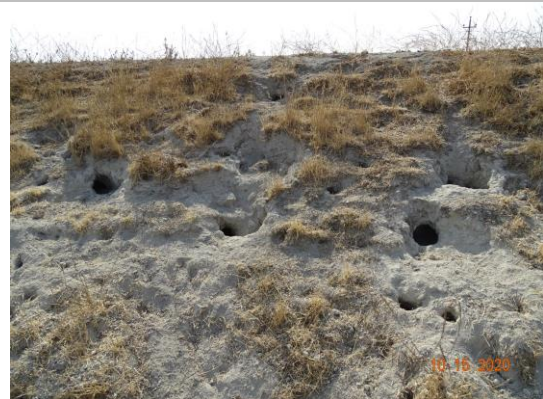
Photo 1 of 1 : SP_2024_NA0010_123_162_20240212_00049.jpg

LM Start	26.99	Rating **	U	Issue No.	162
LM End	27.04	Issue Type +	Ma	Location *	LS
Category	Earthen Levee			GPS Latitude/Longitude	
				Start	End
Item	Animal Control			37.032651 °	37.032659 °
				-120.473205 °	-120.472190 °
DWR ID	DWR_NA0010_05_f_2018_162				
Comment Code					
A1 : Exterminate rodents and backfill and compact or grout burrows.					
Inspector Comment					
Several rodent burrows with large quantities of material displaced noted in this section.

Several rodent burrows noted in this section of the levee. (Fall 2020)

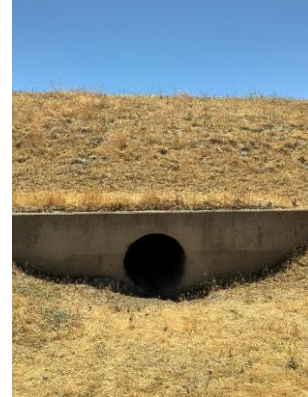
Photo 1 of 3 : UCIP_SP_2024_77903_104356.jpg

Comment Code					
Inspector Comment					
DS_ID:19749 FS_ID:77903 EP_NO: N/A Repair Type: Non-Urgent EVAL Issue: Crossing Status: Found UCIP Comments: 12/20/2022 Record updated from Urgent to Non-Urgent. Pipe has been CIPP-lined. LOF of crossing is less or equal to 4. Recommend next video inspection in 5 years. (O.Yakimov - DWR UCIP) 06/23/2021 The record has been upgraded from No Action Needed to Urgent. DWR DMP internal inspection has found pipe integrity issues. LOF of crossing is greater than or equal to 5 and less than 6. Crossing will be monitored until funding becomes available to address the issues. No permit was found authorizing this encroachment. CVFPB will need to review crossing to determine owner. The UCIP inspection was completed with GEI staff, H.Dunn. (P.Espinoza – GEI) FIELD_STRUCT_DESC: 36-inch CIPP-lined corrugated metal gravity drainage pipe (CMP) through the levee, 12.0 feet below the crown. Flap gate on the waterside (WS) end. Concrete headwall on the landside (LS) end. Concrete U-shaped headwall on the WS end. [Additional Reference(s): DWR Levee Log, 2002, (HLM 27.21). USACE San Joaquin O&M Manual, Unit No. 601, Part No. 1, 1967, Amended in 1978, Revised 20 June 1985, (HLM 27.22). DWR As-Built Specification No. 64-01, Sheet No. 10, 6 November 1963, (HLM 27.22)]. FS Date: 6/23/2021 9:46:35 AM

LS view from toe: concrete headwall at inlet.

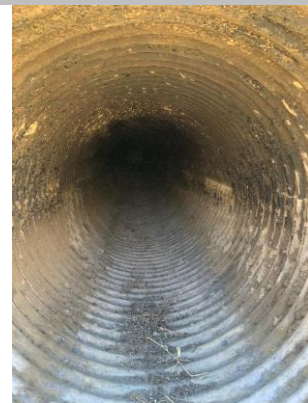
Photo 2 of 3 : UCIP_SP_2024_77903_104357.jpg

LS view from toe: inside of inlet.

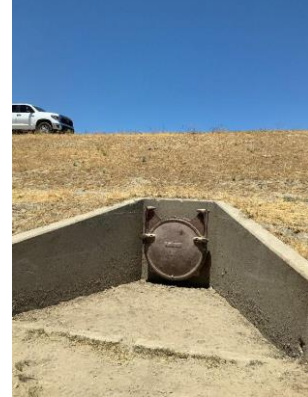
Photo 3 of 3 : UCIP_SP_2024_77903_104355.jpg

WS view from toe: flapgate on concrete headwall at outlet.

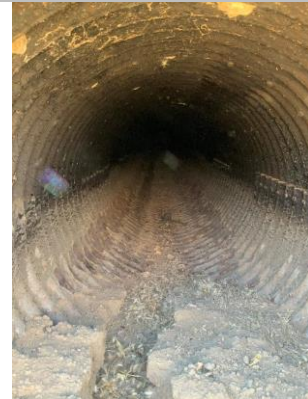
Photo 1 of 3 : UCIP_SP_2024_77904_104322.jpg

DS_ID:19751
FS_ID:77904
EP_NO: N/A
Repair Type: Non-Urgent
EVAL Issue: 11, Maintenance Compliance Issue
Crossing Status: Found
UCIP Comments: 12/20/2022 Record updated from Urgent to Non-Urgent. Pipe has been CIPP-lined. LOF of crossing is less or equal to 4. Recommend next video inspection in 5 years. (O.Yakimov - DWR UCIP)
06/23/2021 The record has been upgraded from No Action Needed to Urgent. DWR DMP internal inspection has found pipe integrity issues. LOF of crossing is between 5 and 6. Crossing will be monitored until funding becomes available to address the issues. Sediment build up in LS pipe inlet; recommend removal. No permit was found authorizing this encroachment. CVFPB will need to review crossing to determine owner. The UCIP inspection was completed with GEI staff, H.Dunn.
(P.Espinoza – GEI)
FIELD_STRUCT_DESC: 30-inch CIPP-lined corrugated metal gravity drainage pipe (CMP) through the levee, 9.8 feet below the crown. Flap gate on the waterside (WS) end. Concrete headwall on the landside (LS) end. Concrete U-shaped headwall on the WS end. [Additional Reference(s): DWR Levee Log, 2002, (HLM 28.69). USACE San Joaquin O&M Manual, Unit No. 601, Part No. 1, 1967, Amended in 1978, Revised 20 June 1985, (HLM 28.69). DWR As-Built Specification No. 64-01, Sheet No. 11, 6 November 1963, (HLM 28.69)].

LS view: inside of pipe.

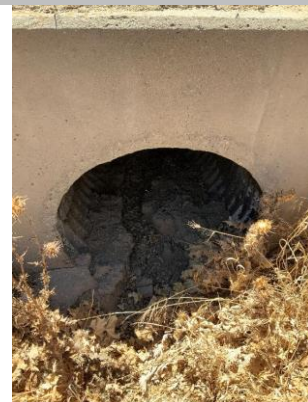
Photo 2 of 3 : UCIP_SP_2024_77904_104323.jpg

LS view from toe: closeup of entrance to pipe.

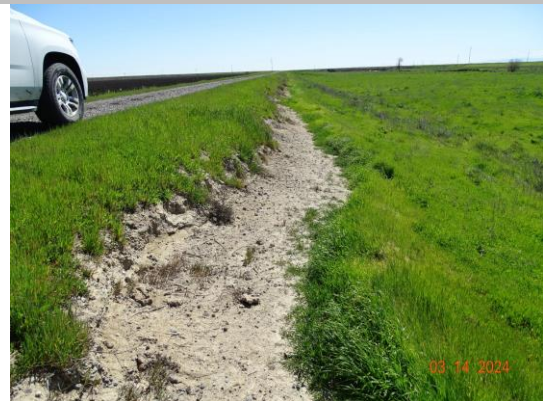
Photo 1 of 1 : SP_2024_NA0010_123_164_20240326_00296.jpg

LM Start	29.43	Rating **	M	Issue No.	164
LM End	29.56	Issue Type +	Ma	Location *	WS
Category	Earthen Levee			GPS Latitude/Longitude	
				Start	End
Item	Erosion / Livestock			37.023481°	37.021794°
				-120.435960°	-120.434769°
DWR ID	DWR_NA0010_05_f_2018_164				
Comment Code					
E4 : Repair the levee slope damaged by livestock and prevent large animal access.					
Inspector Comment					
There is slope damage on waterside from livestock traffic.

Looking upstream along the waterside slope.

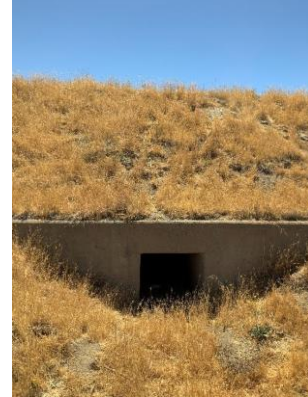
Photo 2 of 3 : UCIP_SP_2024_77865_104305.jpg

LM Start	29.82	Rating **	U	Issue No.	1389 (cont)
LM End	29.82	Issue Type +	Ma	Location *	
Category	Supplemental		GPS Latitude/Longitude		
			Start	End	
Item	DWR UCIP LMA Responsibility		37.018505°	37.018505°	
			-120.432544°	-120.432544°	
DWR ID	19754

LS view from toe: concrete headwall at inlet.

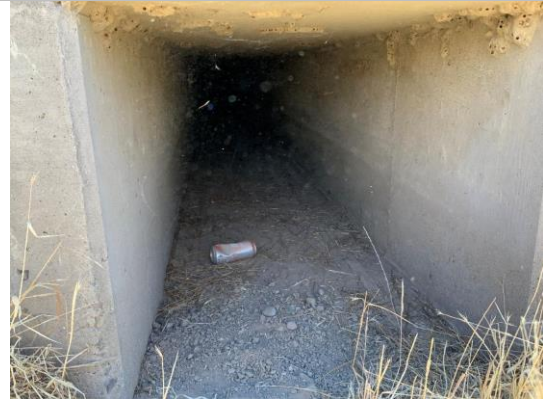
Photo 3 of 3 : UCIP_SP_2024_77865_104306.jpg

LS view from toe: inside of inlet.

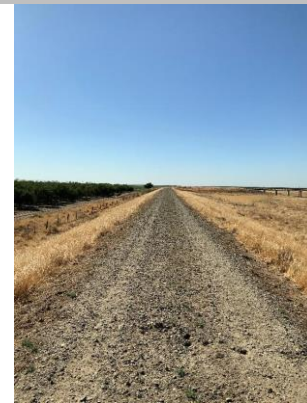
Photo 1 of 3 : UCIP_SP_2024_71079_104289.jpg

Comment Code						
Inspector Comment						
DS_ID:19697						
FS_ID:71079						
EP_NO: N/A						
Repair Type: Non-Urgent						
EVAL Issue:						
Crossing Status: Found						
UCIP Comments: 06/24/2021 The record remains Non-Urgent.						
Crossing appears to be in good condition. No permit was found authorizing this encroachment. CVFPB will need to review crossing to determine owner. The UCIP inspection was completed with GEI staff, H.Dunn. (P.Espinoza – GEI) 03/27/2014 Some debris buildup at LS toe. Dense vegetation limits the inspector's visibility to identify signs of pipe failure (leaks) along the landward slope. Recommend removing vegetation along pipe alignment to conduct proper inspection of structure. (W. Wylie - DWR UCIP)						
FIELD_STRUCT_DESC: 30-inch by 30-inch reinforced concrete box gravity drainage culvert (RCBC) through the levee, 13.3 feet below the crown. Flap gate on the waterside (WS) end. Concrete headwall on the landside (LS) end. Concrete U-shaped headwall on the WS end.

Levee crown.

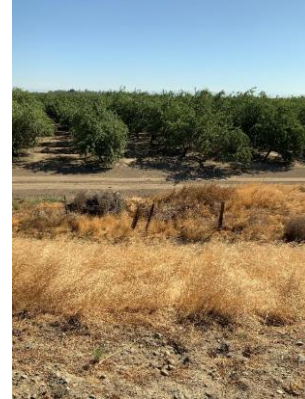
Photo 2 of 3 : UCIP_SP_2024_71079_104291.jpg

LM Start	31.06	Rating **	M	Issue No.	1391 (cont)
LM End	31.06	Issue Type +	Ma	Location *	
Category	Supplemental			GPS Latitude/Longitude	
				Start	End
Item	DWR UCIP LMA Responsibility			37.004212°	37.004212°
				-120.419178°	-120.419178°
DWR ID	19697

LS view from crown.

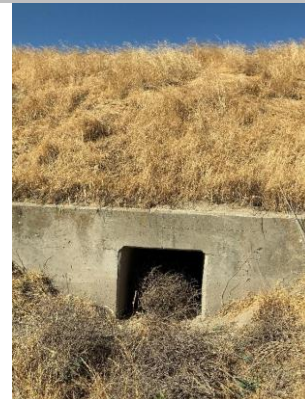
Photo 3 of 3 : UCIP_SP_2024_71079_104294.jpg

LS view from toe: concrete headwall at inlet.

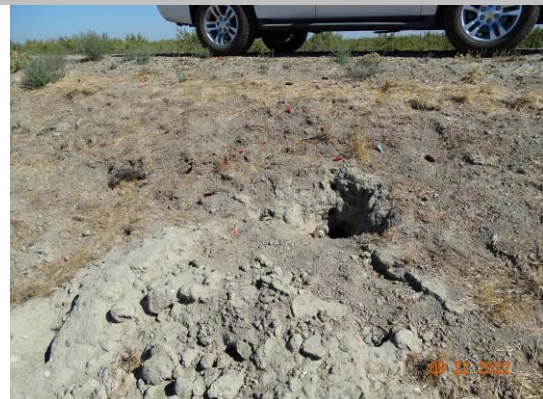
Photo 1 of 1 : SP_2024_NA0010_123_193_20240212_00071.jpg

LM Start	31.17	Rating **	M	Issue No.	193
LM End	31.17	Issue Type +	Ma	Location *	WS
Category	Earthen Levee			GPS Latitude/Longitude	
				Start	End
Item	Animal Control			37.003104°	37.003104°
				-120.417833°	-120.417833°
DWR ID	DWR_NA0010_05_f_2022_193				
Comment Code					
A3 : No rodents visible, but rodent burrows visible; need to backfill and compact or grout burrows.					
Inspector Comment

View of animal burrow in the waterside slope. (Fall 2022)

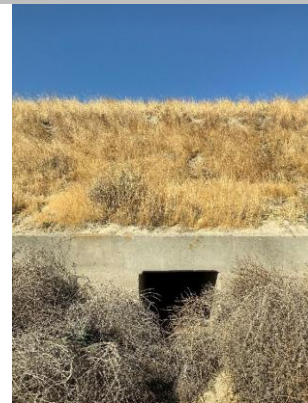
Photo 1 of 2 : UCIP_SP_2024_71080_104285.jpg

Comment Code						
Inspector Comment						
DS_ID:19698 FS_ID:71080 EP_NO: N/A Repair Type: Non-Urgent EVAL Issue: 11, Maintenance Compliance Issue Crossing Status: Found UCIP Comments: 06/24/2021 The record remains Non-Urgent. Some tumbleweed buildup over WS flapgate and LS inlet, recommend removal. No permit was found authorizing this encroachment. CVFPB will need to review crossing to determine owner. The UCIP inspection was completed with GEI staff, H.Dunn. (P.Espinoza – GEI)						
03/27/2014 Excess vegetation buildup at inlet on LS toe. Dense vegetation limits the inspector's visibility to identify signs of pipe failure (leaks) along the landward slope. Recommend removing vegetation along pipe alignment to conduct proper inspection of structure. (W. Wylie - DWR UCIP) FIELD_STRUCT_DESC: 30-inch by 30-inch reinforced concrete box gravity drainage culvert (RCBC) through the levee, 13.4 feet below the crown. Flap gate on the waterside (WS) end. Concrete headwall on the landside (LS) end. Concrete U-shaped headwall on the WS end. [Additional Reference(s): DWR Levee Log, 2002, (HLM 31.20). USACE San Joaquin O&M Manual, Unit No. 601, Part No. 1, 1967, Amended in 1978, Revised 20 June 1985, (HLM 31.19). DWR As-Built Specification No. 64-42, Sheet No. 7, 13 August 1964, (HLM 31.19)]. FS Date: 6/24/2021 2:32:00 PM

LS view from toe: concrete headwall at inlet.

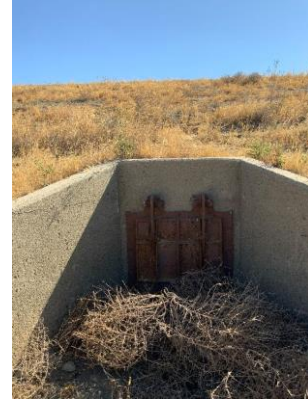
Photo 2 of 2 : UCIP_SP_2024_71080_104287.jpg

LM Start	31.30	Rating **	M	Issue No.	1392 (cont)
LM End	31.30	Issue Type +	Ma	Location *	
Category	Supplemental		GPS Latitude/Longitude		
			Start	End	
Item	DWR UCIP LMA Responsibility		37.001754°	37.001754°	
			-120.416254°	-120.416254°	
DWR ID	19698

WS view from toe: flapgate on concrete headwall at outlet.

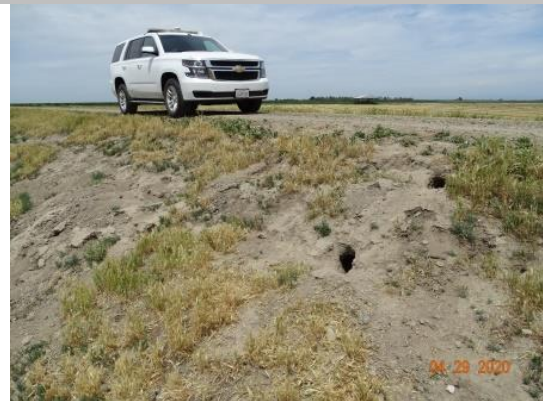
Photo 1 of 1 : SP_2024_NA0010_123_230_20240212_00074.jpg

LM Start	31.66	Rating **	U	Issue No.	230
LM End	31.66	Issue Type +	Ma	Location *	WS
Category	Earthen Levee			GPS Latitude/Longitude	
				Start	End
Item	Animal Control			36.997828°	36.997828°
				-120.411920°	-120.411920°
DWR ID	DWR_NA0010_05_s_2020_230				
Comment Code					
A3 : No rodents visible, but rodent burrows visible; need to backfill and compact or grout burrows.					
Inspector Comment					
Several rodent burrows in the waterside slope and shoulder.

Rodent burrows in the waterside slope. (Spring 2020)

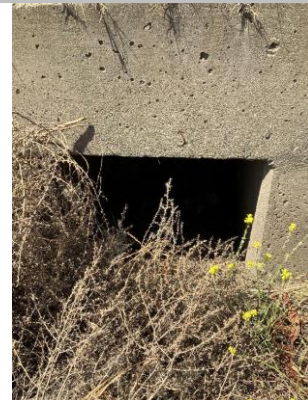
Photo 2 of 2 : UCIP_SP_2024_71083_104265.jpg

LS view from toe: closeup of inlet.

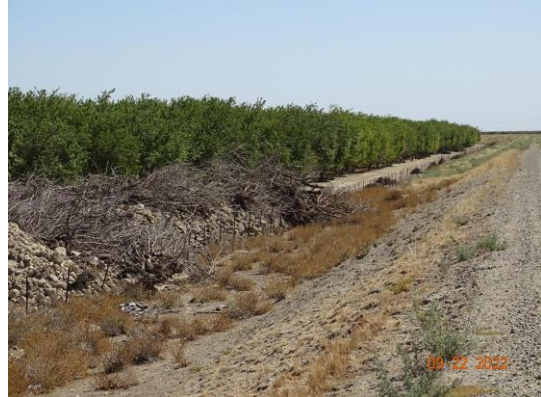
Photo 1 of 1 : SP_2024_NA0010_123_196_20240212_00072.jpg

LM Start	33.08	Rating **	M	Issue No.	196
LM End	33.08	Issue Type +	En	Location *	LS
Category	Earthen Levee			GPS Latitude/Longitude	
				Start	End
Item	Encroachments			36.981182°	36.981182°
				-120.393448°	-120.393448°
DWR ID	DWR_NA0010_05_f_2022_196				
Comment Code					
DE : Debris					
Inspector Comment					
Tree prunings and material are beginning to encroach the levee easement and landside toe.

Debris encroaching into the landside easement and toe. (Fall 2022)

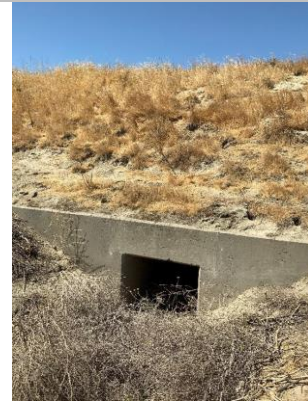
Photo 1 of 2 : UCIP_SP_2024_71084_104257.jpg

Comment Code						
Inspector Comment						
DS_ID:19702 FS_ID:71084 EP_NO: N/A Repair Type: Non-Urgent EVAL Issue: 11, Maintenance Compliance Issue Crossing Status: Found UCIP Comments: 06/23/2021 The record remains Non-Urgent. Some tumbleweed buildup over WS flapgate and LS inlet, recommend removal. No permit was found authorizing this encroachment. CVFPB will need to review crossing to determine owner. The UCIP inspection was completed with GEI staff, H.Dunn. (P.Espinoza – GEI) 04/01/2014 Dense vegetation limits the inspector's visibility to identify signs of pipe failure (leaks) along the landward slope. Recommend removing vegetation along pipe alignment to conduct proper inspection of structure. Debris buildup blocking landward headwall--recommend contacting owner to clear debris. (W. Wylie - DWR UCIP) FIELD_STRUCT_DESC: 30-inch by 30-inch reinforced concrete box gravity drainage culvert (RCBC) through the levee, 12.2 feet below the crown. Flap gate on the waterside (WS) end. Concrete headwall on the landside (LS) end. Concrete U-shaped headwall on the WS end. [Additional Reference(s): DWR Levee Log, 2002, (HLM 33.02). USACE San Joaquin O&M Manual, Unit No. 601, Part No. 1, 1967, Amended in 1978, Revised 20 June 1985, (HLM 33.01). DWR As-Built Specification No. 64-42, Sheet No. 9, 13 August 1964, (HLM 33.01)]. FS Date: 6/23/2021 12:49:00 PM

LS view from toe: concrete headwall at inlet.

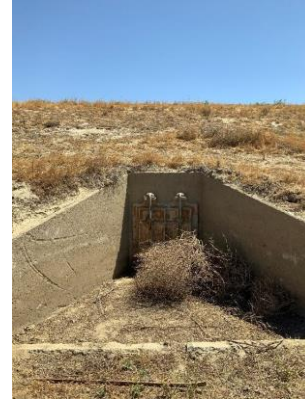
Photo 2 of 2 : UCIP_SP_2024_71084_104259.jpg

LM Start	33.11	Rating **	M	Issue No.	1396 (cont)
LM End	33.11	Issue Type +	Ma	Location *	
Category	Supplemental		GPS Latitude/Longitude		
			Start	End	
Item	DWR UCIP LMA Responsibility		36.980861°	36.980861°	
			-120.393116°	-120.393116°	
DWR ID	19702

WS view from toe: flapgate on concrete headwall at outlet.

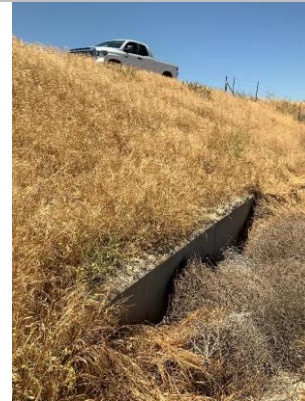
Photo 1 of 2 : UCIP_SP_2024_71085_104252.jpg

DS_ID:19703
 FS_ID:71085
 EP_NO: N/A
 Repair Type: Non-Urgent
 EVAL Issue: 11, Maintenance Compliance Issue
 Crossing Status: Found
 UCIP Comments: 06/24/2021 The record remains Non-Urgent. Limited inspection of LS and WS due to dense vegetation; recommend removal. No permit was found authorizing this encroachment. CVFPB will need to review crossing to determine owner. The UCIP inspection was completed with GEI staff, H.Dunn. (P.Espinoza – GEI) 04/01/2014
 Dense vegetation limits the inspector's visibility to identify signs of pipe failure (leaks) along the slopes. Recommend removing vegetation along pipe alignment to conduct proper inspection of structure. (W. Wylie - DWR UCIP)
 FIELD_STRUCT_DESC: 30-inch by 30-inch reinforced concrete box gravity drainage culvert (RCBC) through the levee, 13.9 feet below the crown. Flap gate on the waterside (WS) end. Concrete headwall on the landside (LS) end. Concrete U-shaped headwall on the WS end.

LS view from toe: concrete headwall and inlet.

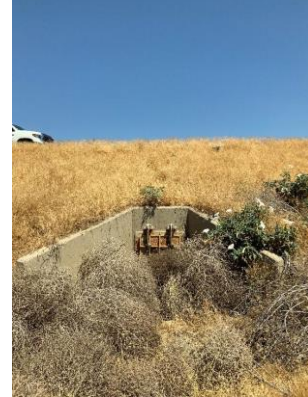
Photo 2 of 2 : UCIP_SP_2024_71085_104250.jpg

LM Start	33.81	Rating **	M	Issue No.	1397 (cont)
LM End	33.81	Issue Type +	Ma	Location *	
Category	Supplemental		GPS Latitude/Longitude		
			Start	End	
Item	DWR UCIP LMA Responsibility		36.976808 °	36.976808 °	
			-120.382593 °	-120.382593 °	
DWR ID	19703

WS view from toe: flapgate on concrete headwall.

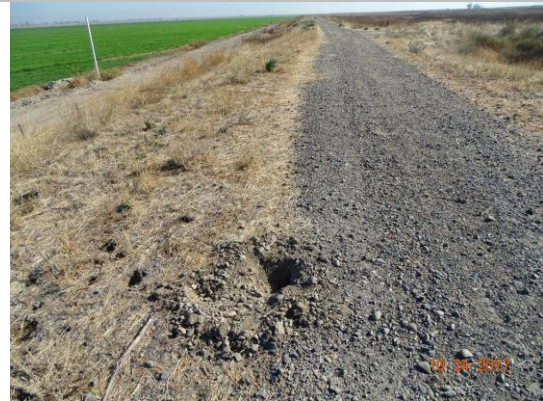
Photo 1 of 1 : SP_2024_NA0010_123_130_20240212_00026.jpg

LM Start	33.82	Rating **	M	Issue No.	130
LM End	33.82	Issue Type +	Ma	Location *	LS
Category	Earthen Levee			GPS Latitude/Longitude	
				Start	End
Item	Animal Control			36.976849 °	36.976849 °
				-120.382393 °	-120.382393 °
DWR ID	DWR_NA0010_05_f_2017_130				
Comment Code					
A3 : No rodents visible, but rodent burrows visible; need to backfill and compact or grout burrows.					
Inspector Comment

Looking east at the landside shoulder.

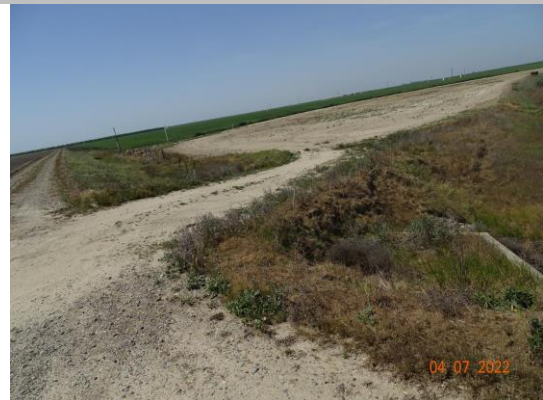
Photo 1 of 1 : SP_2024_NA0010_123_189_20240212_00068.jpg

LM Start	34.60	Rating **	M	Issue No.	189
LM End	34.60	Issue Type +	En	Location *	LS
Category	Earthen Levee			GPS Latitude/Longitude	
				Start	End
Item	Encroachments			36.978525 °	36.978525 °
				-120.368661 °	-120.368661 °
DWR ID	DWR_NA0010_05_s_2022_189				
Comment Code					
RA : Ramp					
Inspector Comment

View of ramp on the landside slope. (Spring 2022)

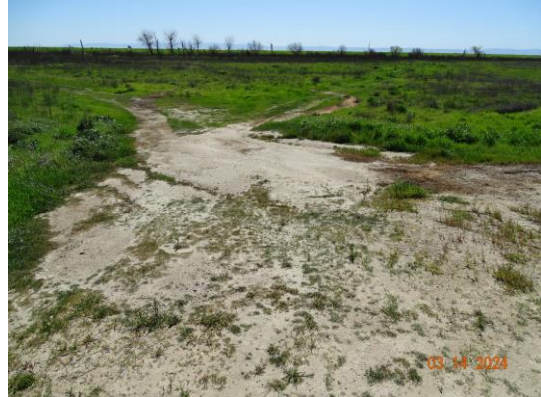
Photo 1 of 1 : SP_2024_NA0010_123_11_20240326_00297.jpg

LM Start	34.61	Rating **	M	Issue No.	11
LM End	34.61	Issue Type +	En	Location *	WS
Category	Earthen Levee			GPS Latitude/Longitude	
				Start	End
Item	Encroachments			36.978523 °	36.978523 °
				-120.368520 °	-120.368520 °
DWR ID	DWR_NA0010_05_s_2012_11				
Comment Code					
RA : Ramp					
Inspector Comment					
There is an unauthorized ramp on waterside slope. Landowner cut unauthorized ramp on waterside slope and levee crown.

Looking west at ramp on waterward slope. (Spring 2024)

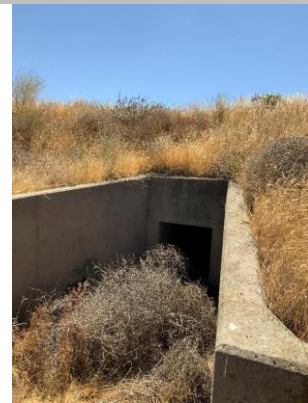
Photo 1 of 2 : UCIP_SP_2024_71086_104243.jpg

Comment Code					
Inspector Comment					
DS_ID:19755 FS_ID:71086 EP_NO: N/A Repair Type: Non-Urgent EVAL Issue: 11, Maintenance Compliance Issue Crossing Status: Found UCIP Comments: 06/24/2021 The record remains Non-Urgent. Limited inspection of WS and LS due to dense vegetation, recommend removal. No permit was found authorizing this encroachment. CVFPB will need to review crossing to determine owner. The UCIP inspection was completed with GEI staff, H.Dunn. (P.Espinoza – GEI) 04/01/2014 Dense vegetation limits the inspector's visibility to identify signs of pipe failure (leaks) along the landward slope. Recommend removing vegetation along pipe alignment to conduct proper inspection of structure. Debris buildup visible on waterward headwall--recommend contacting owner to clear pipe. (W. Wylie - DWR UCIP) FIELD_STRUCT_DESC: [Chowchilla Canal Irrigation Structure] 36-inch by 36-inch reinforced concrete box gravity irrigation culvert (RCBC) through the levee, 9.7 feet below the crown. Slide gate in a 56-inch by 91-inch concrete riser unit on the waterside (WS) slope. Concrete U-shaped headwall on each end. Landside channel cobble revetted for 8 feet. [Additional Reference(s): DWR Levee Log, 2002, (HLM 34.51). USACE San Joaquin O&M Manual, Unit No. 601, Part No. 1, 1967, Amended in 1978, Revised 20 June 1985, (HLM 34.51). DWR As-Built Specification No. 64-42, Sheet No. 10, 13 August 1964, (HLM 34.51)]. FS Date: 6/24/2021 11:58:00 AM

LS view from toe: concrete headwall and inlet.

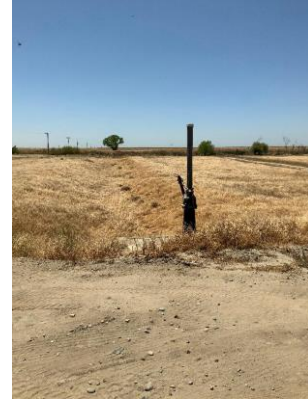
Photo 2 of 2 : UCIP_SP_2024_71086_104242.jpg

WS view from crown. Slide gate in concrete riser visible in background.
