Flood Control Project Maintenance
Levee Inspections
LMA District Cover Sheet

Lower San Joaquin Levee District

**Flood Control Project Maintenance
Levee Inspections
Unit Cover Sheet**

Levee Inspection Report By Mile - Spring 2024

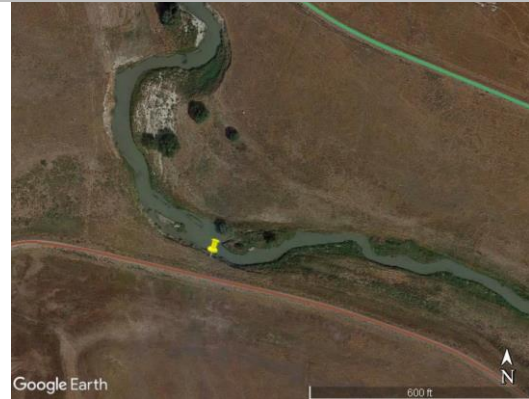
Photo 2 of 2 : SP_2024_NA0010_124_2_20240212_00004.jpg

LM Start	0.10	Rating **	U	Issue No.	2
LM End	0.14	Issue Type +	Ma	Location *	WS
Category	Supplemental			GPS Latitude/Longitude	
				Start	End
Item	DWR Erosion Survey			37.275701°	37.275701°
				-120.823773°	-120.823773°
DWR ID	NA0010U06RM0.41				
Comment Code					
Inspector Comment					
Site ID: NA0010U06RM0.41					
8/17/2023: From 2022 to present, no significant changes were observed during the annual survey.					
08/09/2022: The site was discovered by the LMA and visited during the annual field survey. There is a 20-ft vertical scarp running along the bank and encroaching into the extended levee prism. The berm is 10-12 ft wide.

9/13/2022: Aerial view of the erosion site (Google Earth Imagery from 9/27/2020).

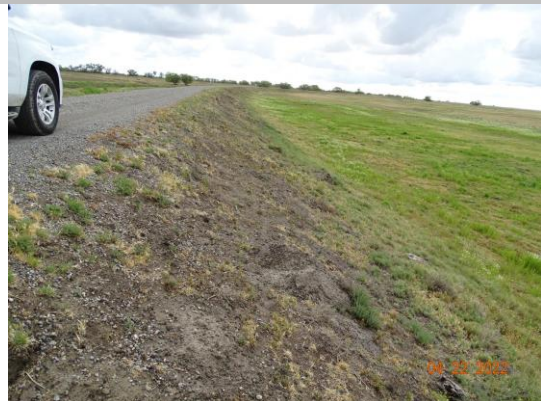
Photo 1 of 1 : SP_2024_NA0010_124_147_20240212_00065.jpg

LM Start	0.14	Rating **	M	Issue No.	147
LM End	0.14	Issue Type +	Ma	Location *	LS
Category	Earthen Levee			GPS Latitude/Longitude	
				Start	End
Item	Animal Control			37.275637°	37.275637°
				-120.823438°	-120.823438°
DWR ID	DWR_NA0010_06_s_2022_147				
Comment Code					
A3 : No rodents visible, but rodent burrows visible; need to backfill and compact or grout burrows.					
Inspector Comment

View of rodent burrows on the landside slope. (Spring 2022)

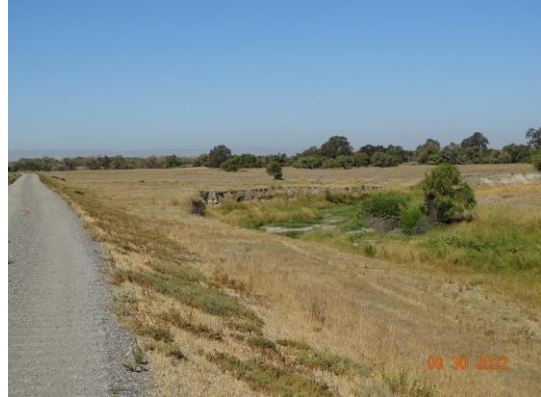
Photo 1 of 1 : SP_2024_NA0010_124_106_20240212_00033.jpg

LM Start	0.14	Rating **	A/W	Issue No.	106
LM End	0.17	Issue Type +	Ma	Location *	WS
Category	Earthen Levee			GPS Latitude/Longitude	
				Start	End
Item	Erosion / Bank Caving			37.275640°	37.275541°
				-120.823419°	-120.822833°
DWR ID	DWR_NA0010_06_f_2022_106				
Comment Code					
E2 : Schedule repair of erosion site prior to the next inspection.					
Inspector Comment					
Erosion is approximately 10 feet from toe. It is within the theoretical prism. Erosion is approximately 20 feet in height and 250 feet in length.

Erosion on the waterside toe has cut into the theoretical prism. (Fall 2022)

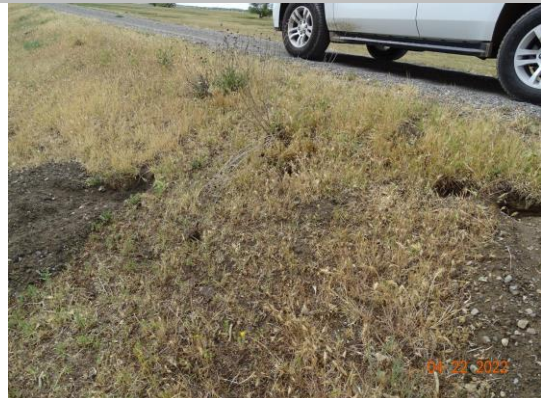
Photo 1 of 1 : SP_2024_NA0010_124_148_20240212_00066.jpg

LM Start	0.43	Rating **	M	Issue No.	148
LM End	0.43	Issue Type +	Ma	Location *	WS
Category	Earthen Levee			GPS Latitude/Longitude	
				Start	End
Item	Animal Control			37.273651°	37.273651°
				-120.818813°	-120.818813°
DWR ID	DWR_NA0010_06_s_2022_148				
Comment Code					
A1 : Exterminate rodents and backfill and compact or grout burrows.					
Inspector Comment

View of active rodent burrows on waterside slope. (Spring 2022)

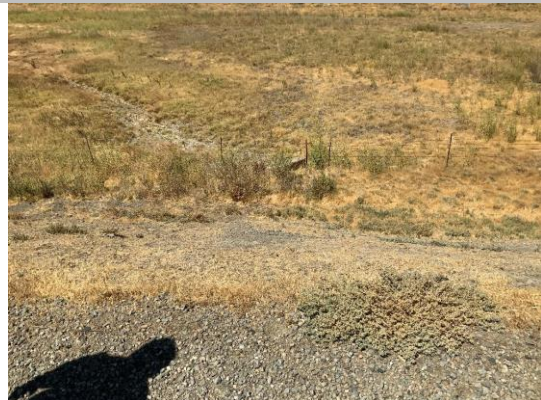
Photo 2 of 3 : UCIP_SP_2024_71092_102877.jpg

LS view: Toe from crown.

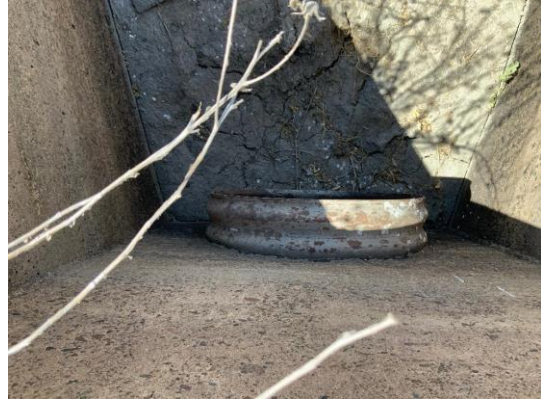
Photo 3 of 3 : UCIP_SP_2024_71092_102879.jpg

LS view: Top view of pipe inlet at toe.

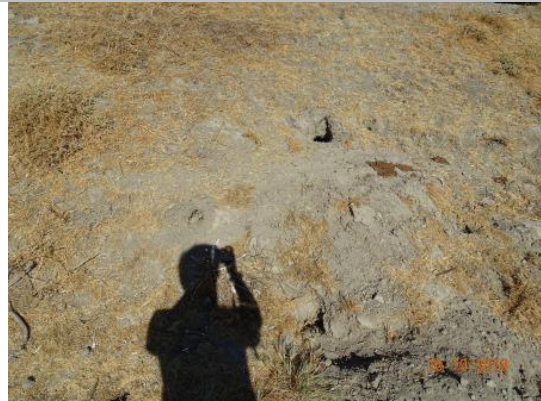
Photo 1 of 1 : SP_2024_NA0010_124_93_20240212_00028.jpg

LM Start	1.18	Rating **	A/W	Issue No.	93
LM End	1.18	Issue Type +	Ma	Location *	LS
Category	Earthen Levee			GPS Latitude/Longitude	
				Start	End
Item	Animal Control			37.267101°	37.267101°
				-120.809603°	-120.809603°
DWR ID	DWR_NA0010_06_f_2018_93				
Comment Code					
A1 : Exterminate rodents and backfill and compact or grout burrows.					
Inspector Comment					
Several rodent burrows including large burrows were observed at this location.

View of landside slope. (Fall 2018)

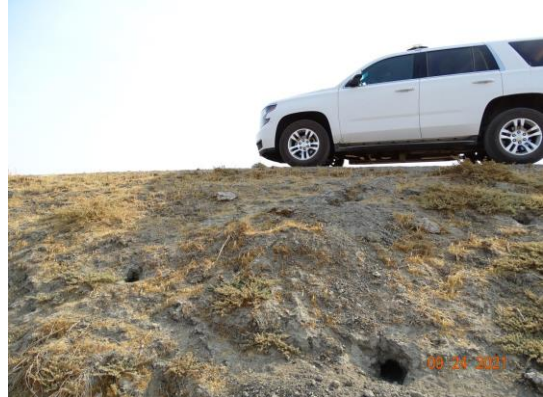
Photo 1 of 1 : SP_2024_NA0010_124_127_20240212_00047.jpg

LM Start	1.52	Rating **	M	Issue No.	127
LM End	1.52	Issue Type +	Ma	Location *	LS
Category	Earthen Levee			GPS Latitude/Longitude	
				Start	End
Item	Animal Control			37.263176°	37.263176°
				-120.805983°	-120.805983°
DWR ID	DWR_NA0010_06_f_2021_127				
Comment Code					
A3 : No rodents visible, but rodent burrows visible; need to backfill and compact or grout burrows.					
Inspector Comment

View of rodent burrows in the landside slope. (Fall 2021)

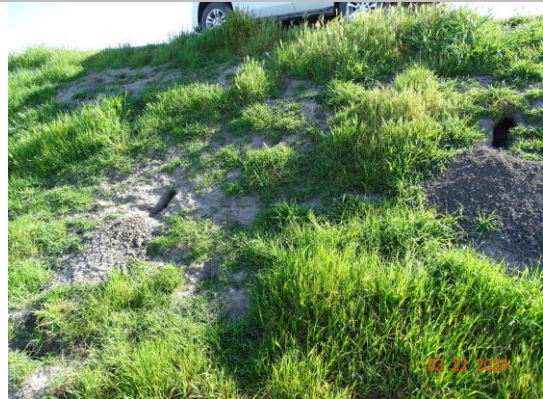
Photo 1 of 1 : SP_2024_NA0010_124_58_20240326_00151.jpg

LM Start	1.60	Rating **	M	Issue No.	58
LM End	1.60	Issue Type +	Ma	Location *	LS
Category	Earthen Levee			GPS Latitude/Longitude	
				Start	End
Item	Animal Control			37.261952°	37.261952°
				-120.805894°	-120.805894°
DWR ID	DWR_NA0010_06_s_2024_58				
Comment Code					
A3 : No rodents visible, but rodent burrows visible; need to backfill and compact or grout burrows.					
Inspector Comment

View of multiple rodent burrows on the landside slope. (Spring 2024)

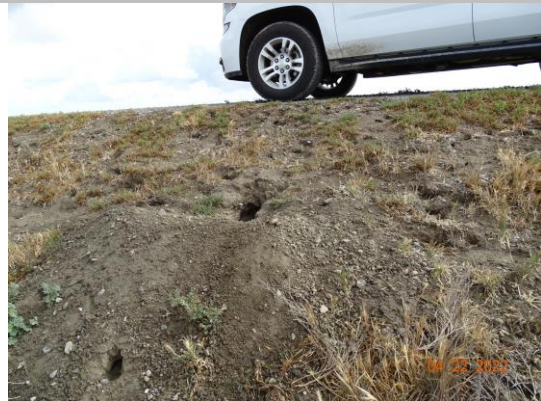
Photo 1 of 1 : SP_2024_NA0010_124_146_20240212_00064.jpg

LM Start	2.23	Rating **	M	Issue No.	146
LM End	2.23	Issue Type +	Ma	Location *	LS
Category	Earthen Levee			GPS Latitude/Longitude	
				Start	End
Item	Animal Control			37.256445°	37.256445°
				-120.797508°	-120.797508°
DWR ID	DWR_NA0010_06_s_2022_146				
Comment Code					
A3 : No rodents visible, but rodent burrows visible; need to backfill and compact or grout burrows.					
Inspector Comment					
A few rodent burrows observed in this section with large quantities of material displaced.

View of rodent holes on the landside slope. (Spring 2022)

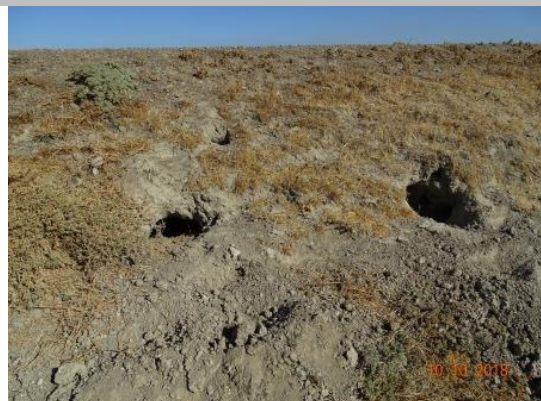
Photo 1 of 1 : SP_2024_NA0010_124_92_20240212_00027.jpg

LM Start	2.42	Rating **	A/W	Issue No.	92
LM End	2.42	Issue Type +	Ma	Location *	LS
Category	Earthen Levee			GPS Latitude/Longitude	
				Start	End
Item	Animal Control			37.254519°	37.254519°
				-120.795141°	-120.795141°
DWR ID	DWR_NA0010_06_f_2018_92				
Comment Code					
A3 : No rodents visible, but rodent burrows visible; need to backfill and compact or grout burrows.					
Inspector Comment

View of large rodent holes in landside slope. (Fall 2018)

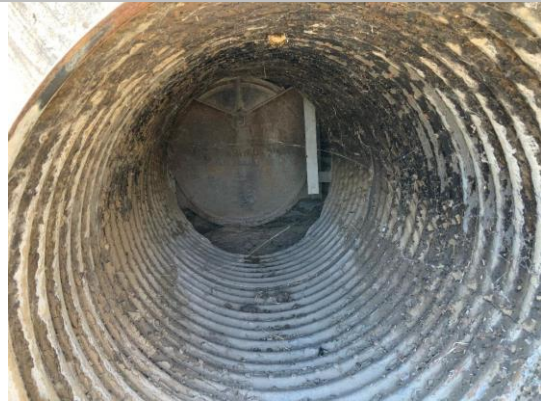
Photo 1 of 1 : UCIP_SP_2024_71094_102912.jpg

Comment Code					
Inspector Comment					
DS_ID:19818 FS_ID:71094 EP_NO: N/A Repair Type: Non-Urgent EVAL Issue: 5, Pipe Damage Crossing Status: Found UCIP Comments: 07/27/2021 The record remains Non-Urgent. DWR DMP internal inspection has found pipe integrity issues. LOF of crossing is between 4.1 and 5. Crossing will be monitored until funding becomes available for rehabilitation. No permit was found authorizing this encroachment. CVFPB will need to review crossing to determine owner. The UCIP inspection was completed with GEI staff, P. Espinoza. (H. Dunn – GEI) 04/18/2014 Need to contact owner. Sediment buildup in pipe visible on landward side. (O. Magana - DWR UCIP) FIELD_STRUCT_DESC: 36-inch corrugated metal gravity drainage pipe (CMP) through the levee, 6.9 feet below the crown. Slide gate in a 48-inch CMP riser unit on the waterside (WS) slope. Concrete headwall on each end. [Additional Reference(s): DWR Levee Log, 2002, (HLM 2.61). USACE San Joaquin O&M Manual, Unit No. 601, Part No. 1, 1967, Amended in 1978, Revised 20 June 1985, (HLM 2.61). DWR As-Built Specification No. 61-01, Sheet No. 46, 7 March 1961, (HLM 2.61)]. FS Date: 7/27/2021

WS view: Inside pipe outlet at toe.

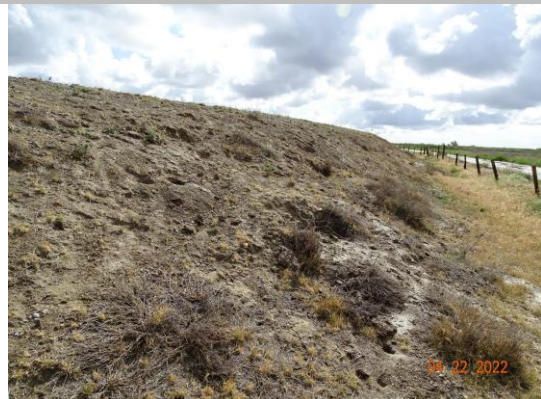
Photo 1 of 1 : SP_2024_NA0010_124_76_20240212_00017.jpg

LM Start	2.54	Rating **	A/W	Issue No.	76
LM End	2.54	Issue Type +	Ma	Location *	LS
Category	Earthen Levee			GPS Latitude/Longitude	
				Start	End
Item	Animal Control			37.252874°	37.252874°
				-120.794192°	-120.794192°
DWR ID	DWR_NA0010_06_f_2016_76				
Comment Code					
A3 : No rodents visible, but rodent burrows visible; need to backfill and compact or grout burrows.					
Inspector Comment					
There are several rodent burrows in the landside slope at this location.

View of rodent holes on the landside slope looking upstream. (Spring 2022)

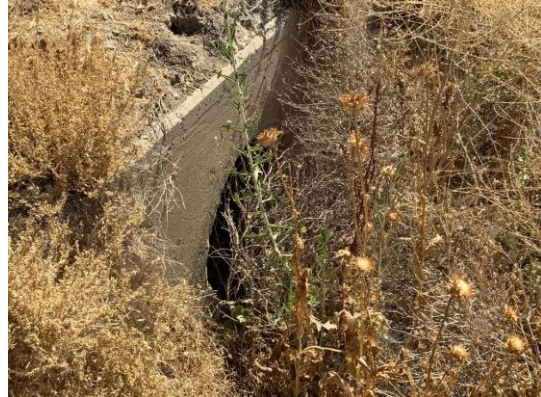
Photo 1 of 1 : UCIP_SP_2024_71095_102921.jpg

Comment Code						
Inspector Comment						
DS_ID:19819 FS_ID:71095 EP_NO: N/A Repair Type: Non-Urgent EVAL Issue: Crossing Status: Found UCIP Comments: 09/18/2023 Pipe was CIPP lined. DMP internal video inspection has found none or minor pipe defects. Recommend next video inspection in 5 years. (O. Yakimov - DWR UCIP) 07/27/2021 The record remains Non-Urgent. DWR DMP internal inspection has found pipe integrity issues. LOF of crossing is between 4.1 and 5. Crossing will be monitored until funding becomes available for rehabilitation. Dense vegetation covering LS pipe inlet, limited inspection and recommend removal. No permit was found authorizing this encroachment. CVFPB will need to review crossing to determine owner. The UCIP inspection was completed with GEI staff, P. Espinoza. (H. Dunn – GEI) 04/18/2014 Dense vegetation limits the inspector's visibility to identify signs of pipe condition on landward toe--headwall blocked by dense vegetation. Recommend removing vegetation from landward toe. (O. Magana - DWR UCIP) FIELD_STRUCT_DESC: 24-inch CIPP-lined corrugated metal gravity drainage pipe (CMP) through the levee, 9.2 feet below the crown. Flap gate on the waterside (WS) end. Concrete headwall on each end. [Additional Reference(s): DWR Levee Log, 2002, (HLM 2.65). USACE San Joaquin O&M Manual, Unit No. 601, Part No. 1, 1967, Amended in 1978, Revised 20 June 1985, (HLM 2.65). DWR As-Built Specification No. 61-01, Sheet No. 46, 7 March 1961, (HLM 2.65)]. FS Date: 7/27/2021

LS view: Closeup of pipe inlet at toe with dense vegetation.

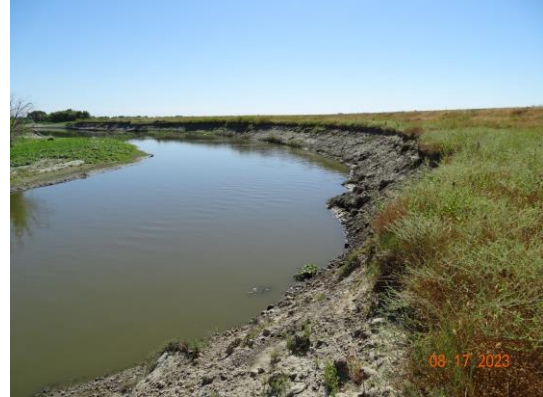
Photo 1 of 2 : SP_2024_NA0010_124_1_20240212_00001.jpg

LM Start	2.61	Rating **	U	Issue No.	1
LM End	2.68	Issue Type +	Ma	Location *	WS
Category	Supplemental			GPS Latitude/Longitude	
				Start	End
Item	DWR Erosion Survey			37.252596°	37.252596°
				-120.792504°	-120.792504°
DWR ID	NA0010U06RM3.01				
Comment Code					
Inspector Comment					
Site ID: NA0010U06RM3.01					
8/17/2023: From 2022 to present, no significant changes were observed during the annual survey.					
08/09/2022: The site was discovered by the LMA and visited during the annual field survey. There is a 15-20 ft scarp, vertical in some locations, running along the bank. The berm is 15 ft wide at the narrowst section.

8/17/2023: View of the erosion looking upstream.

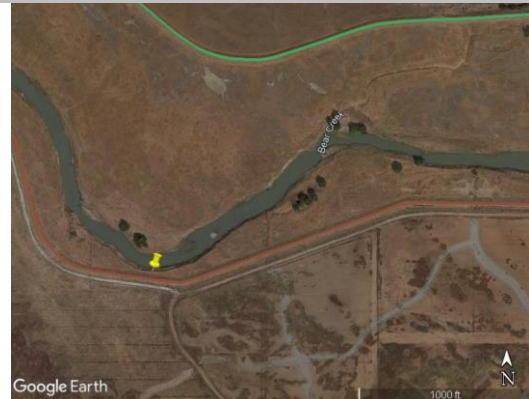
Photo 2 of 2 : SP_2024_NA0010_124_1_20240212_00002.jpg

9/13/2022: Aerial view of the erosion site (Google Earth Imagery from 9/27/2020).

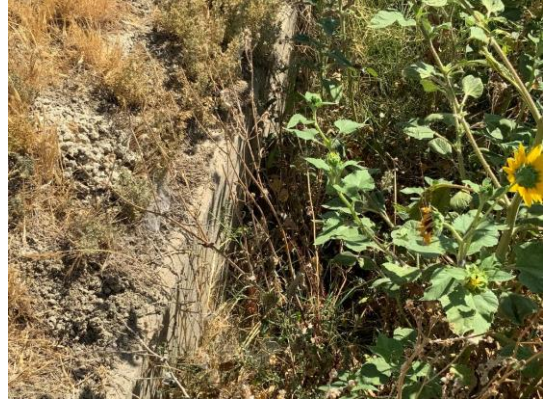
Photo 1 of 2 : UCIP_SP_2024_77923_102930.jpg

DS_ID:19820
FS_ID:77923
EP_NO: N/A
Repair Type: Non-Urgent
EVAL Issue: 6, Levee Damage or Threat for Levee Damage
Crossing Status: Found
UCIP Comments: 12/20/2022 Record updated from Urgent to Non-Urgent. Pipe has been CIPP lined. LOF of crossing is less or equal to 4. Recommend next video inspection in 5 years. (O.Yakimov - DWR UCIP)
07/27/2021 The record has been upgraded from Non-Urgent to Urgent. DWR DMP internal inspection has found pipe integrity issues. LOF of crossing is greater than or equal to 5 and less than 6. Crossing will be monitored until funding becomes available to address the issues. Dense vegetation covering LS pipe inlet, limited inspection and recommend removal of vegetation. Some minor erosion under WS concrete pad, less than a foot in length. No permit was found authorizing this encroachment. CVFPB will need to review crossing to determine owner. The UCIP inspection was completed with GEI staff, P. Espinoza. (H. Dunn – GEI) 04/18/2014 Dense vegetation limits the inspector's visibility to identify signs of pipe condition on landward toe--headwall blocked by dense vegetation. Recommend removing vegetation from landward toe. (O. Magana - DWR UCIP)

LS view: Closeup of pipe inlet at toe covered with vegetation.

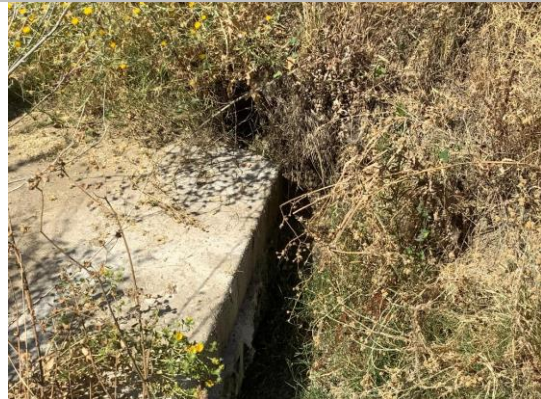
Photo 2 of 2 : UCIP_SP_2024_77923_102927.jpg

WS view: Some erosion underneath concrete pad.

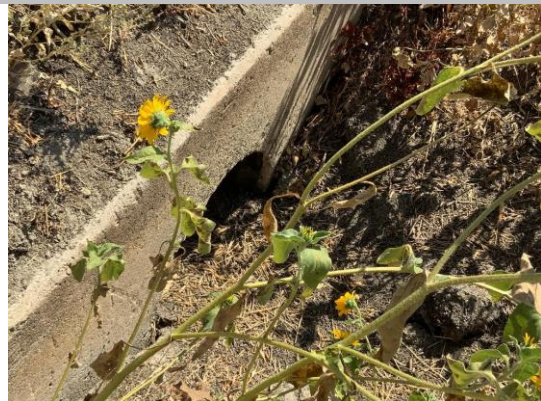
Photo 1 of 2 : UCIP_SP_2024_71097_102947.jpg

DS_ID:19821
 FS_ID:71097
 EP_NO: N/A
 Repair Type: Non-Urgent
 EVAL Issue: 11, Maintenance Compliance Issue
 Crossing Status: Found
 UCIP Comments: 07/27/2021 The record remains Non-Urgent. Limited inspection due to sediment and debris buildup inside LS pipe inlet, recommend removal. Sediment buildup keeping WS flapgate open, recommend removal. No permit was found authorizing this encroachment. CVFPB will need to review crossing to determine owner. The UCIP inspection was completed with GEI staff, P. Espinoza. (H. Dunn – GEI) 04/18/2014 Dense vegetation limits the inspector's visibility to identify signs of pipe condition on landward toe--headwall blocked by dense vegetation. Recommend removing vegetation from landward toe. (O. Magana - DWR UCIP)
 FIELD_STRUCT_DESC: 24-inch corrugated metal gravity drainage pipe (CMP) through the levee, 11.2 feet below the crown. Flap gate on the waterside (WS) end. Concrete headwall on each end. [Additional Reference(s): DWR Levee Log, 2002, (HLM 3.09). USACE San Joaquin O&M Manual, Unit No. 601, Part No. 1, 1967, Amended in 1978, Revised 20 June 1985, (HLM 3.09). DWR As-Built Specification No. 61-01, Sheet No. 47, 7 March 1961, (HLM 3.09)].

LS view: Closeup of pipe inlet at toe with dense sediment and debris inside.

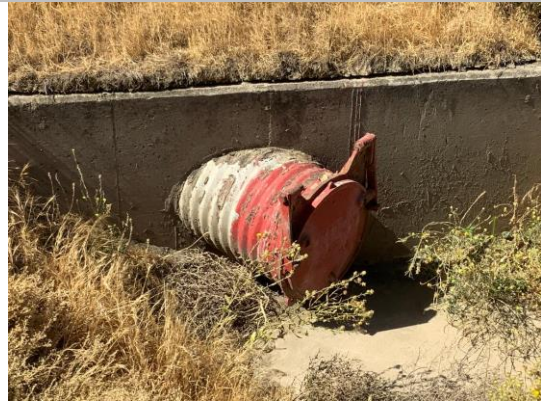
Photo 2 of 2 : UCIP_SP_2024_71098_102951.jpg

WS view: Closeup of flapgate at toe.

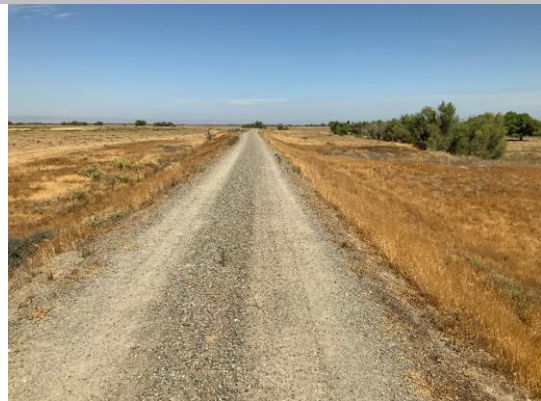
Photo 1 of 3 : UCIP_SP_2024_71099_102957.jpg

DS_ID:19823
FS_ID:71099
EP_NO: N/A
Repair Type: Non-Urgent
EVAL Issue:
Crossing Status: Not Found
UCIP Comments: 07/27/2021 The record remains Non-Urgent. No signs of pipe, headwalls, or flapgate found on WS or LS. Confirm with owner on the status of this pipe. No permit was found authorizing this encroachment. CVFPB will need to review crossing to determine owner. The UCIP inspection was completed with GEI staff, P. Espinoza. (H. Dunn – GEI) 04/18/2014 Alignment of crossing unknown--altered crossing. No headwall found on landward side only siphon breaker found a short distance from landward toe. Tall grass observed on waterward slope and some burrow activity also noticed. Need to contact owner to determine alignment of crossing and status of crossing. (O. Magana - DWR UCIP)
FIELD_STRUCT_DESC: 36-inch corrugated metal gravity drainage pipe (CMP) through the levee, 15.7 feet below the crown. Flap gate on the waterside (WS) end. Concrete U-shaped headwall on each end. Bench mark (BM) stamped 9770-152 on top of the WS headwall. [Additional Reference(s): DWR Levee Log, 2002, (HLM 3.44). USACE San Joaquin O&M Manual, Unit No. 601, Part No. 1, 1967, Amended in 1978, Revised 20 June 1985, (HLM 3.43). DWR As-Built Specification No. 61-01, Sheet No. 47, 7 March 1961, (HLM 3.43)].

Levee crown.

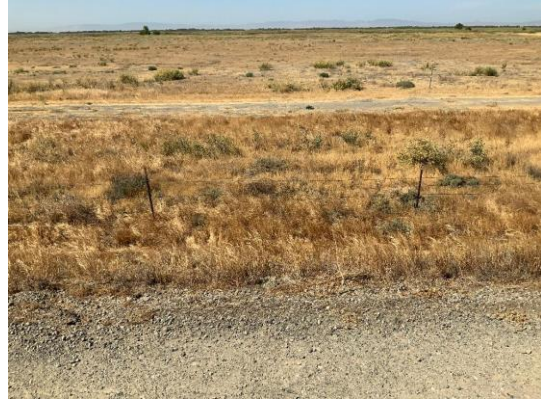
Photo 2 of 3 : UCIP_SP_2024_71099_102958.jpg

LS view: Toe from crown.

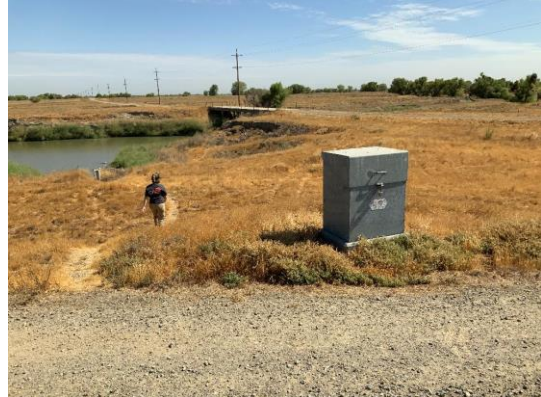
Photo 1 of 1 : UCIP_SP_2024_71100_102967.jpg

Comment Code						
Inspector Comment						
DS_ID:19824 FS_ID:71100 EP_NO: 6965 Repair Type: Non-Urgent EVAL Issue: 10, Unauthorized Modification or Non-Compliant Permit Crossing Status: Indicator Found UCIP Comments: 07/27/2021 The record remains Non-Urgent. Crossing appears to be modified, there is no WS pump or platform. No sign of pipe visible on LS, unless pipe goes to large plant facility off the toe. Confirm with owner on the alignment and status of pipe. The UCIP inspection was completed with GEI staff, P. Espinoza. (H. Dunn – GEI)						
04/18/2014 Description of structure does not match. Need to contact owner. Current description includes concrete platform, trash screen, and gage reading on waterward side. Metal box located on waterward shoulder. Large plant facility locate on landward side. (O. Magana - DWR UCIP) FIELD_STRUCT_DESC: 16-inch coated steel irrigation discharge pipe through the levee, 7.4 feet below the crown. Corrugated metal (CM) cutoff wall around the pipe at the center of the levee. Pump on the waterside (WS) with a timber platform on the berm for support. Siphon breaker on the apex of the pipe on the landside (LS) shoulder. Pipe exposed on both slopes. (20-inch irrigation pipe authorized under Permit No. 6965, 1971 - Scarborough, Robinson, and Associates). [Additional Reference(s): DWR Levee Log, 2002, (HLM 3.44)]. FS Date: 7/27/2021

WS view: Toe from crown.

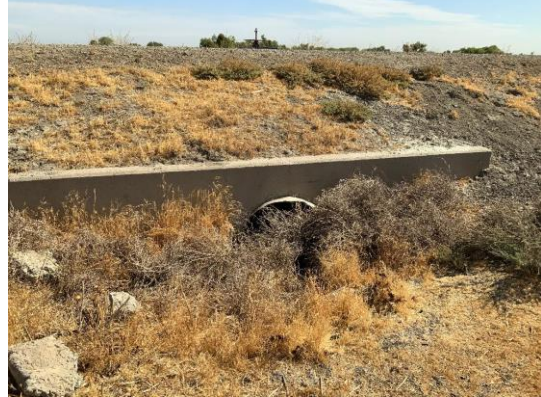
Photo 1 of 3 : UCIP_SP_2024_71101_102973.jpg

Comment Code						
Inspector Comment						
DS_ID:19825 FS_ID:71101 EP_NO: N/A Repair Type: Non-Urgent EVAL Issue: 4b, Safety Issue Crossing Status: Found UCIP Comments: 07/27/2021 The record remains Non-Urgent. DWR DMP internal inspection has found pipe integrity issues. LOF of crossing is between 4.1 and 5. Crossing will be monitored until funding becomes available for rehabilitation. WS riser has broken cover, creating a safety hazard. Limited inspection due to dense tumbleweeds over LS inlet, recommend removal. No permit was found authorizing this encroachment. CVFPB will need to review crossing to determine owner. The UCIP inspection was completed with GEI staff, P. Espinoza. (H. Dunn – GEI) 04/18/2014 Sediment buildup inside pipe visible from landward side. Excess soil is also present on landward toe partially blocking concrete headwall and inlet. Recommend removing soil from landward toe and clear buildup inside. (O. Magana - DWR UCIP) FIELD_STRUCT_DESC: 36-inch corrugated metal gravity drainage pipe (CMP) through the levee, 6.8 feet below the crown. Slide gate in a 48-inch CMP riser unit on the waterside (WS) slope. Concrete headwall on each end. Pipe connects to a 30-inch steel drainage pipe on the WS. Drainage pipe extends to the pump on the WS on a support platform in the channel. (30-inch drainage pipe and pump authorized under Permit No. 12527, 1979 - Joseph Gallo). [Additional Reference(s): DWR Levee Log, 2002, (HLM 3.54). USACE San Joaquin O&M Manual, Unit No. 601, Part No. 1, 1967, Amended in 1978, Revised 20 June 1985, (HLM 3.54). DWR As-Built Specification No. 61-01, Sheet No. 47, 7 March 1961, (HLM 3.54)]. FS Date: 7/27/2021

LS view: Headwall and slope from toe.

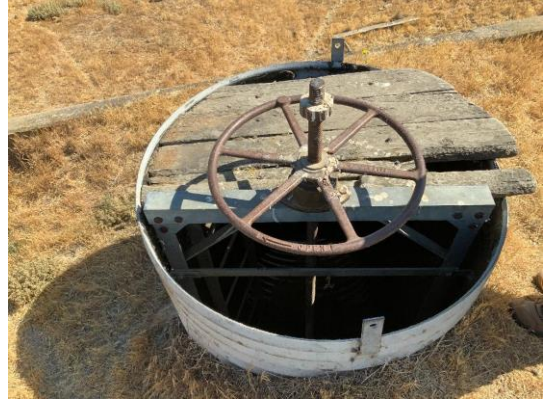
Photo 2 of 3 : UCIP_SP_2024_71101_102977.jpg

WS view: Closeup of the riser on the slope with missing cover.

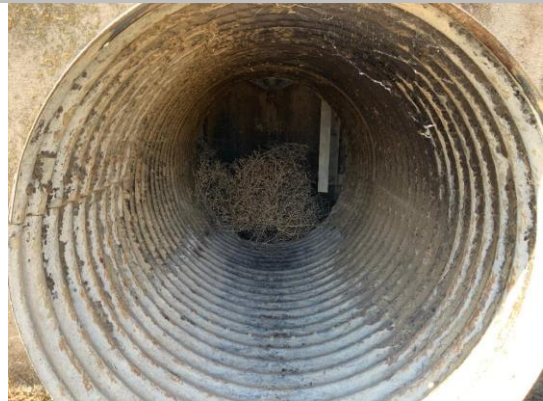
Photo 3 of 3 : UCIP_SP_2024_71101_102971.jpg

WS view: Inside of pipe outlet at toe.

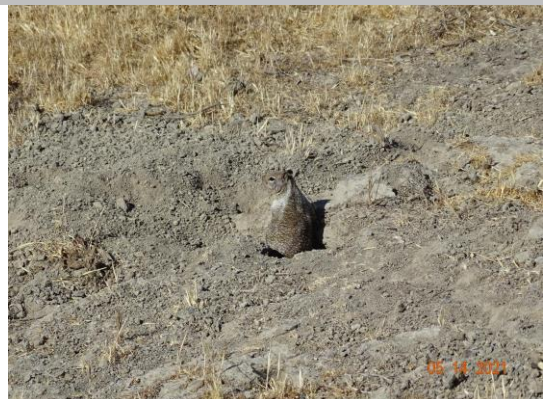
Photo 1 of 1 : SP_2024_NA0010_124_67_20240212_00011.jpg

LM Start	3.49	Rating **	M	Issue No.	67
LM End	3.49	Issue Type +	Ma	Location *	LS
Category	Earthen Levee			GPS Latitude/Longitude	
				Start	End
Item	Animal Control			37.251602°	37.251602°
				-120.778118°	-120.778118°
DWR ID	DWR_NA0010_06_f_2017_67				
Comment Code					
A1 : Exterminate rodents and backfill and compact or grout burrows.					
Inspector Comment

View of active rodent and burrow on the landside slope. (Spring 2021)

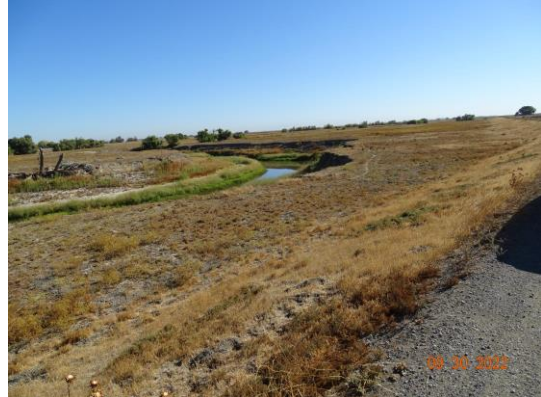
Photo 1 of 1 : SP_2024_NA0010_124_96_20240212_00029.jpg

LM Start	3.62	Rating **	A/W	Issue No.	96
LM End	3.67	Issue Type +	Ma	Location *	WS
Category	Earthen Levee			GPS Latitude/Longitude	
				Start	End
Item	Erosion / Bank Caving			37.251226°	37.251140°
				-120.775774°	-120.774900°
DWR ID	DWR_NA0010_06_f_2022_96				
Comment Code					
E1 : Note and monitor erosion site.					
Inspector Comment					
Erosion is approximately 30 ft from levee toe, 18 ft in height, and 150 ft in length.

View of erosion on the waterside berm. (Fall 2022)

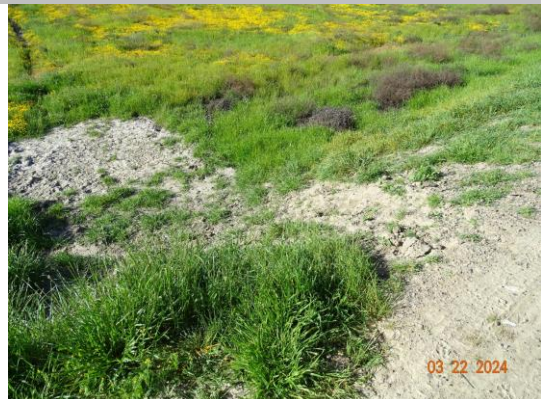
Photo 1 of 1 : SP_2024_NA0010_124_122_20240326_00152.jpg

LM Start	3.68	Rating **	A/W	Issue No.	122
LM End	3.68	Issue Type +	Ma	Location *	LS
Category	Earthen Levee			GPS Latitude/Longitude	
				Start	End
Item	Erosion / Livestock			37.251161°	37.251161°
				-120.774659°	-120.774659°
DWR ID	DWR_NA0010_06_f_2021_122				
Comment Code					
E4 : Repair the levee slope damaged by livestock and prevent large animal access.					
Inspector Comment

View of slope damage due to animal traffic. (Spring 2024)

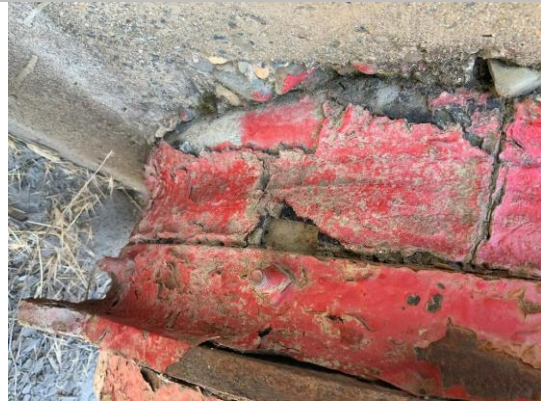
Photo 2 of 2 : UCIP_SP_2024_71102_102980.jpg

WS view: Closeup of liner deterioration on flapgate at toe.

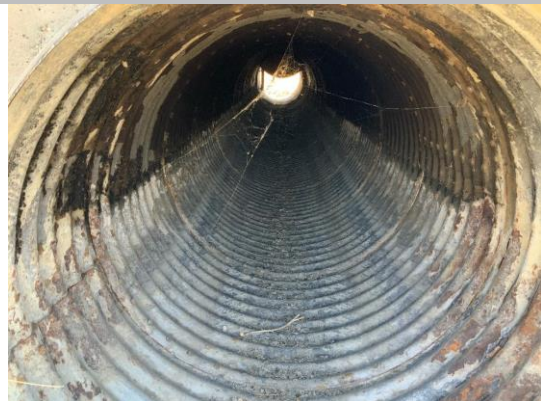
Photo 1 of 2 : UCIP_SP_2024_71103_102997.jpg

DS_ID:19827
 FS_ID:71103
 EP_NO: N/A
 Repair Type: Non-Urgent
 EVAL Issue: 5, Pipe Damage
 Crossing Status: Found
 UCIP Comments: 07/27/2021 The record remains Non-Urgent. DWR DMP internal inspection has found pipe integrity issues. LOF of crossing is between 4.1 and 5. Crossing will be monitored until funding becomes available for rehabilitation. No permit was found authorizing this encroachment. CVFPB will need to review crossing to determine owner. The UCIP inspection was completed with GEI staff, P. Espinoza. (H. Dunn – GEI) 04/18/2014 Sediment buildup inside crossing and is visible from landward side. Recommend clearing sediment buildup inside pipe and check wall integrity to determine condition. (O. Magana - DWR UCIP)
 FIELD_STRUCT_DESC: 36-inch corrugated metal gravity drainage pipe (CMP) through the levee, 6.7 feet below the crown. Slide gate in a 48-inch CMP riser unit on the waterside (WS) slope. [Additional Reference(s): DWR Levee Log, 2002, (HLM 3.98). USACE San Joaquin O&M Manual, Unit No. 601, Part No. 1, 1967, Amended in 1978, Revised 20 June 1985, (HLM 3.97). DWR As-Built Specification No. 61-01, Sheet No. 47, 7 March 1961, (HLM 3.97)].

LS view: Inside pipe inlet at toe.

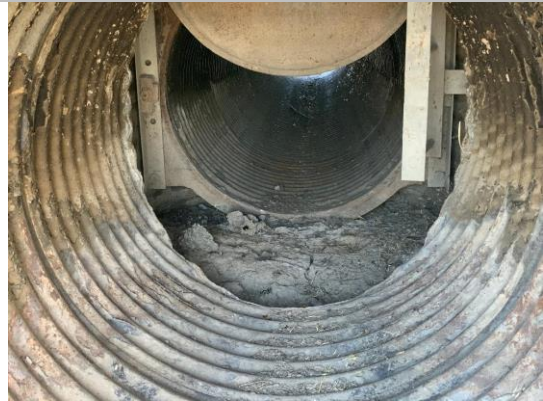
Photo 2 of 2 : UCIP_SP_2024_71103_102993.jpg

WS view: Inside pipe outlet at toe.

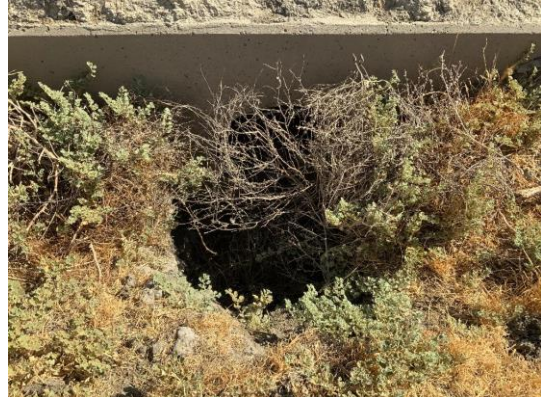
Photo 1 of 1 : UCIP_SP_2024_71105_103022.jpg

Comment Code					
Inspector Comment					
DS_ID:19829 FS_ID:71105 EP_NO: N/A Repair Type: Non-Urgent EVAL Issue: Crossing Status: Found UCIP Comments: 09/18/2023 Pipe was CIPP lined. DMP internal video inspection has found none or minor pipe defects. Recommend next video inspection in 5 years. (O. Yakimov - DWR UCIP) 07/27/2021 The record remains Non-Urgent. DWR DMP internal inspection has found pipe integrity issues. LOF of crossing is between 4.1 and 5. Crossing will be monitored until funding becomes available for rehabilitation. Limited inspection due to LS pipe inlet having some vegetation overgrowth over it, recommend removal. No permit was found authorizing this encroachment. CVFPB will need to review crossing to determine owner. The UCIP inspection was completed with GEI staff, P. Espinoza. (H. Dunn – GEI) 04/18/2014 Dense vegetation limits the inspector's visibility to identify signs of pipe condition on landward toe--headwall blocked by dense vegetation. Recommend removing vegetation from landward toe. (O. Magana - DWR UCIP) FIELD_STRUCT_DESC: 24-inch CIPP-lined corrugated metal gravity drainage pipe (CMP) through the levee, 11.3 feet below the crown. Flap gate on the waterside (WS) end. Concrete headwall on each end. [Additional Reference(s): DWR Levee Log, 2002, (HLM 4.43). USACE San Joaquin O&M Manual, Unit No. 601, Part No. 1, 1967, Amended in 1978, Revised 20 June 1985, (HLM 4.41). DWR As-Built Specification No. 61-01, Sheet No. 48, 7 March 1961, (HLM 4.41)]. FS Date: 7/27/2021

LS view: Closeup of pipe inlet at toe covered by vegetation.

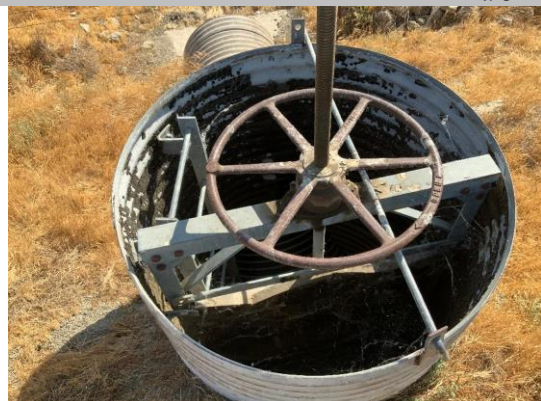
Photo 2 of 2 : UCIP_SP_2024_71106_103027.jpg

WS view: Closeup of riser without lid on slope.

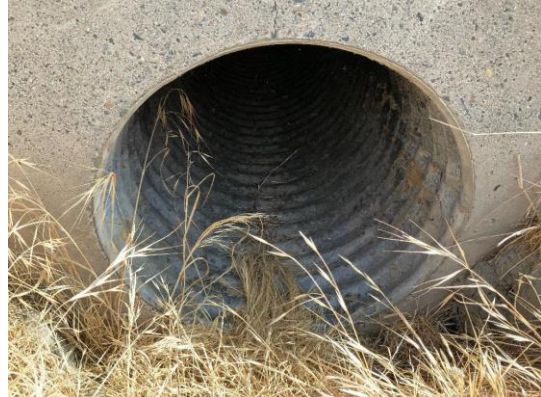
Photo 1 of 2 : UCIP_SP_2024_71109_103070.jpg

DS_ID:19863
FS_ID:71109
EP_NO: N/A
Repair Type: No Action Needed
EVAL Issue:
Crossing Status: Found
UCIP Comments: 09/18/2023 Record updated from Non-Urgent to No Action Needed. Pipe was CIPP lined. DMP internal video inspection has found none or minor pipe defects. Recommend next video inspection in 5 years. (O. Yakimov - DWR UCIP)
07/27/2021 The record remains Non-Urgent. DWR DMP internal inspection has found pipe integrity issues. LOF of crossing is greater than or equal to 4.1 and less than 5. Crossing will be monitored until funding becomes available for rehabilitation. No permit was found authorizing this encroachment. CVFPB will need to review crossing to determine owner. The UCIP inspection was completed with GEI staff, P. Espinoza. (H. Dunn – GEI) 04/18/2014 Clear vegetation from waterward slope and landward headwall. (O. Magana - DWR UCIP)
FIELD_STRUCT_DESC: 24-inch CIPP-lined corrugated metal gravity drainage pipe (CMP) through the levee, 10.9 feet below the crown. Flap gate on the waterside (WS) end. Concrete headwall on each end.

LS view: Closeup of pipe inlet at toe.

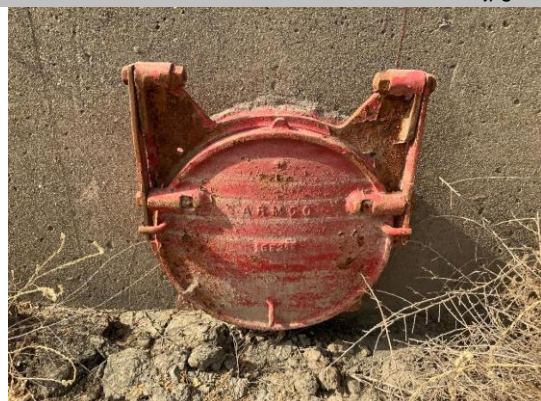
Photo 2 of 2 : UCIP_SP_2024_71109_103066.jpg

WS view: Closeup of flapgate at toe.

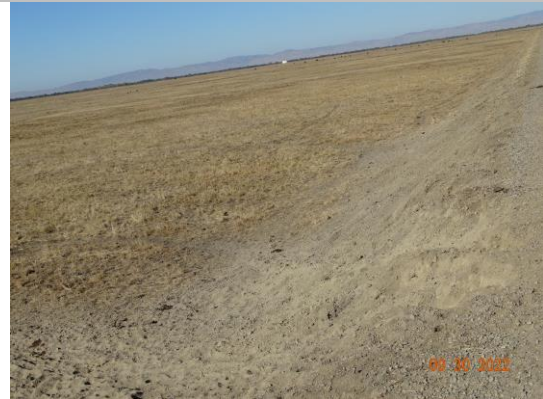
Photo 1 of 1 : SP_2024_NA0010_124_161_20240212_00072.jpg

LM Start	5.42	Rating **	A/W	Issue No.	161
LM End	5.42	Issue Type +	Ma	Location *	LS
Category	Earthen Levee			GPS Latitude/Longitude	
				Start	End
Item	Erosion / Livestock			37.238729°	37.238729°
				-120.748884°	-120.748884°
DWR ID	DWR_NA0010_06_f_2022_161				
Comment Code					
E4 : Repair the levee slope damaged by livestock and prevent large animal access.					
Inspector Comment					
Monitor repair for settlement.

Deep livestock trail on the landside slope. (Fall 2022)

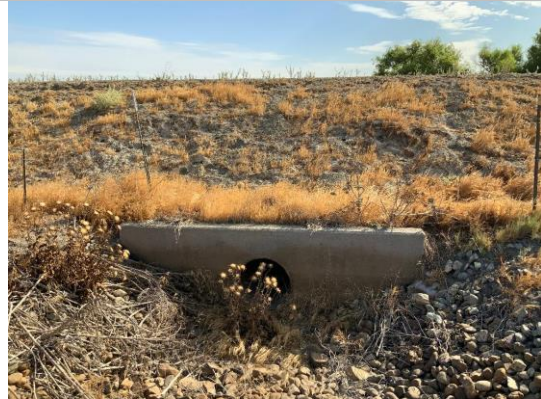
Photo 3 of 3 : UCIP_SP_2024_71111_103094.jpg

LS toe: Headwall and slope from toe.

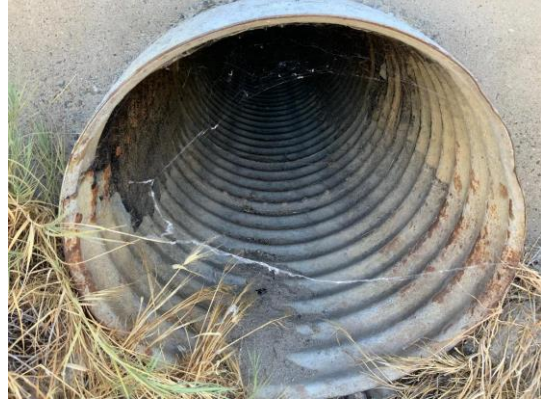
Photo 3 of 3 : UCIP_SP_2024_71112_103107.jpg

LS view: Closeup of pipe inlet at toe.

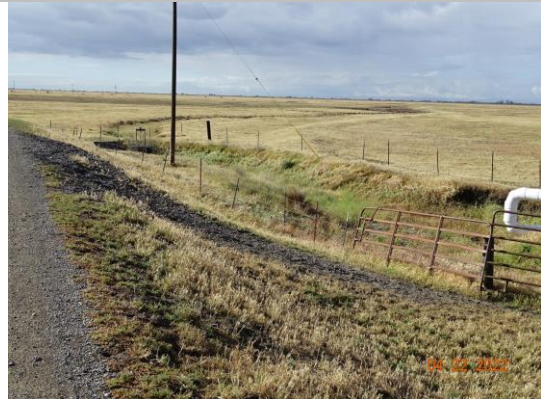
Photo 1 of 1 : SP_2024_NA0010_124_143_20240212_00061.jpg

LM Start	6.88	Rating **	M	Issue No.	143
LM End	6.88	Issue Type +	Ma	Location *	LS
Category	Earthen Levee			GPS Latitude/Longitude	
				Start	End
Item	Erosion / Livestock			37.228370°	37.228370°
				-120.728004°	-120.728004°
DWR ID	DWR_NA0010_06_s_2022_143				
Comment Code					
E4 : Repair the levee slope damaged by livestock and prevent large animal access.					
Inspector Comment

Levee damage on the landside slope from livestock activity. (Spring 2022)

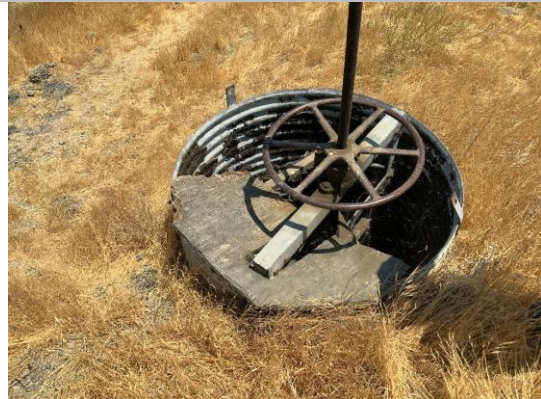
Photo 1 of 1 : UCIP_SP_2024_71113_101626.jpg

Comment Code					
Inspector Comment					
DS_ID:19867 FS_ID:71113 EP_NO: N/A Repair Type: Non-Urgent EVAL Issue: 4b, Safety Issue Crossing Status: Found UCIP Comments: 07/13/2021 The record has been upgraded from No Action Needed to Non-Urgent. The cover on the WS riser is broken, causing a safety concern. There is another riser, pump, and pipe out closer to the channel on the WS but is not within 15 feet of the toe. No permit was found authorizing this encroachment. CVFPB will need to review crossing to determine owner. The UCIP inspection was completed with GEI staff, P. Espinoza. (H. Dunn – GEI) FIELD_STRUCT_DESC: 36-inch corrugated metal gravity drainage pipe (CMP) through the levee, 10.7 feet below the crown. Slide gate in a 48-inch CMP riser unit on the waterside (WS) slope. Concrete headwall on the landside (LS) end. Concrete U-shaped headwall on the WS end. [Additional Reference(s): DWR Levee Log, 2002, (HLM 6.97). USACE San Joaquin O&M Manual, Unit No. 601, Part No. 1, 1967, Amended in 1978, Revised 20 June 1985, (HLM 6.97). DWR As-Built Specification No. 61-01, Sheet No. 50, 7 March 1961, (HLM 6.97)]. FS Date: 7/13/2021

WS view: Closeup of riser on slope with broken lid.

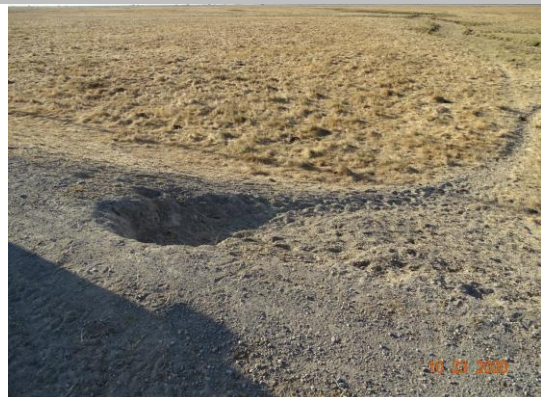
Photo 1 of 1 : SP_2024_NA0010_124_79_20240212_00018.jpg

LM Start	6.92	Rating **	M	Issue No.	79
LM End	6.92	Issue Type +	Ma	Location *	LS
Category	Earthen Levee			GPS Latitude/Longitude	
				Start	End
Item	Erosion / Livestock			37.228054°	37.228054°
				-120.727428°	-120.727428°
DWR ID	DWR_NA0010_06_f_2018_79				
Comment Code					
E4 : Repair the levee slope damaged by livestock and prevent large animal access.					
Inspector Comment					
Slope damage has been repaired with loose soil.

View down the landside slope of damage from livestock. (Fall 2020)

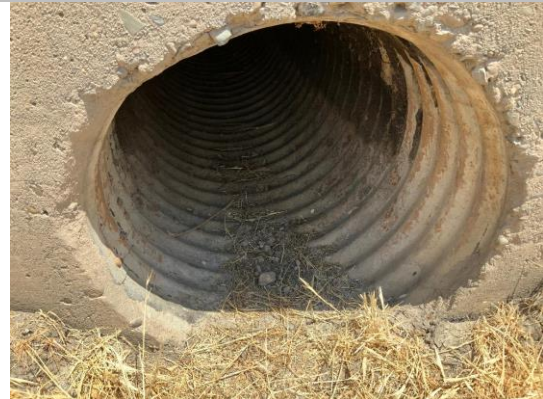
Photo 1 of 2 : UCIP_SP_2024_71114_101633.jpg

Comment Code						
Inspector Comment						
DS_ID:19868 FS_ID:71114 EP_NO: N/A Repair Type: No Action Needed EVAL Issue: Crossing Status: Found UCIP Comments: 09/18/2023 Record updated from Non-Urgent to No Action Needed. Pipe was CIPP lined. DMP internal video inspection has found none or minor pipe defects. Recommend next video inspection in 5 years. (O. Yakimov - DWR UCIP) 07/13/2021 Record is still Non-Urgent. DWR DMP internal inspection has found pipe integrity issues. LOF of crossing is between 4.1 and 5. Crossing will be monitored until funding becomes available for rehabilitation. No permit was found authorizing this encroachment. CVFPB will need to review crossing to determine owner. The UCIP inspection was completed with GEI staff, P. Espinoza. (H. Dunn – GEI) 04/18/2014 Need to contact owner. Clear animal from waterward side. Some sediment buildup in pipe visible landward side--recommend clearing. (O. Magana - DWR UCIP) FIELD_STRUCT_DESC: 24-inch CIPP-lined corrugated metal gravity drainage pipe (CMP) through the levee, 10.6 feet below the crown. Flap gate on the waterside (WS) end. Concrete headwall on each end. [Additional Reference(s): DWR Levee Log, 2002, (HLM 7.29). USACE San Joaquin O&M Manual, Unit No. 601, Part No. 1, 1967, Amended in 1978, Revised 20 June 1985, (HLM 7.29). DWR As-Built Specification No. 61-01, Sheet No. 50, 7 March 1961, (HLM 7.29)]. FS Date: 7/13/2021

LS view: Closeup of pipe inlet at toe.

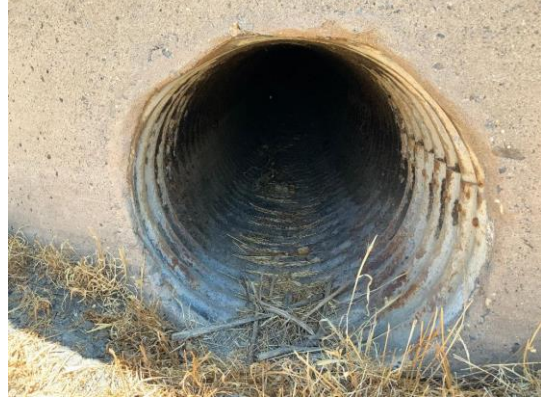
Photo 1 of 2 : UCIP_SP_2024_71115_101646.jpg

Comment Code					
Inspector Comment					
DS_ID:19869 FS_ID:71115 EP_NO: N/A Repair Type: No Action Needed EVAL Issue: Crossing Status: Found UCIP Comments: 09/18/2023 Record updated from Non-Urgent to No Action Needed. Pipe was CIPP lined. DMP internal video inspection has found none or minor pipe defects. Recommend next video inspection in 5 years. (O. Yakimov - DWR UCIP) 07/13/2021 Record remains Non-Urgent. DWR DMP internal inspection has found pipe integrity issues. LOF of crossing is greater than or equal to 4.1 and less than 5. Crossing will be monitored until funding becomes available for rehabilitation. No longer sediment buildup as mentioned in previous inspection. No permit was found authorizing this encroachment. CVFPB will need to review crossing to determine owner. The UCIP inspection was completed with GEI staff, P. Espinoza. (H. Dunn – GEI) 04/18/2014 Some sediment buildup in pipe visible on landward side--recommend clearing. (O. Magana - DWR UCIP) FIELD_STRUCT_DESC: 24-inch CIPP-lined corrugated metal gravity drainage pipe (CMP) through the levee, 11.8 feet below the crown. Flap gate on the waterside (WS) end. Concrete headwall on each end. Skewed crossing. [Additional Reference(s): DWR Levee Log, 2002, (HLM 7.74). USACE San Joaquin O&M Manual, Unit No. 601, Part No. 1, 1967, Amended in 1978, Revised 20 June 1985, (HLM 7.74). DWR As-Built Specification No. 61-01, Sheet No. 50, 7 March 1961, (HLM 7.74)]. FS Date: 7/13/2021

LS view: Closeup of pipe inlet at toe.

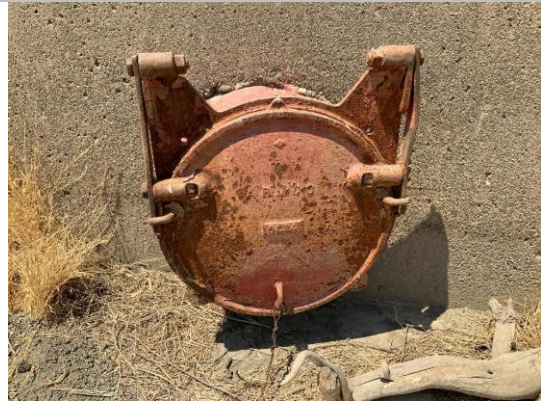
Photo 2 of 2 : UCIP_SP_2024_71115_101642.jpg

WS view: Closeup of flapgate at toe.

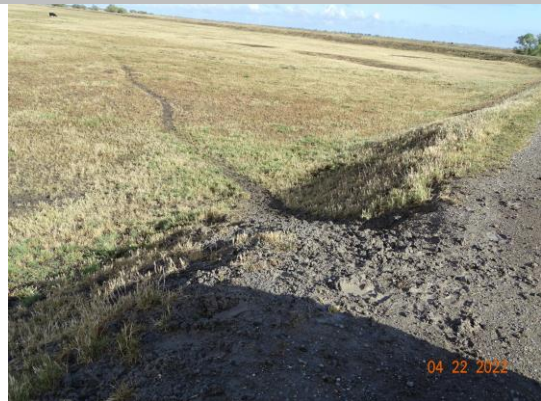
Photo 1 of 1 : SP_2024_NA0010_124_74_20240212_00016.jpg

LM Start	7.66	Rating **	A/W	Issue No.	74
LM End	7.66	Issue Type +	Ma	Location *	LS
Category	Earthen Levee			GPS Latitude/Longitude	
				Start	End
Item	Erosion / Livestock			37.222689°	37.222689°
				-120.716400°	-120.716400°
DWR ID	DWR_NA0010_06_f_2018_74				
Comment Code					
E4 : Repair the levee slope damaged by livestock and prevent large animal access.					
Inspector Comment					
Damage to levee slope from livestock access.

Slope damage from livestock. (Spring 2022)

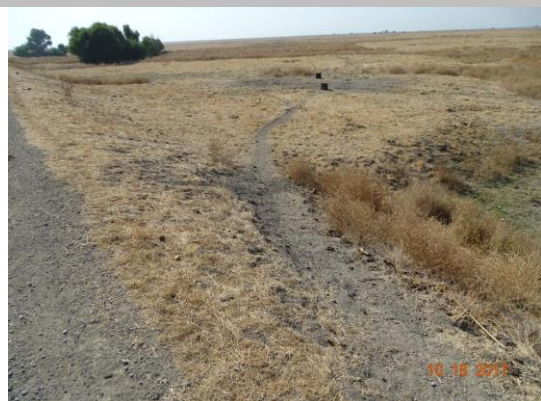
Photo 1 of 1 : SP_2024_NA0010_124_65_20240212_00009.jpg

LM Start	8.08	Rating **	A/W	Issue No.	65
LM End	8.08	Issue Type +	Ma	Location *	LS
Category	Earthen Levee			GPS Latitude/Longitude	
				Start	End
Item	Erosion / Livestock			37.217199°	37.217199°
				-120.713374°	-120.713374°
DWR ID	DWR_NA0010_06_f_2017_65				
Comment Code					
E4 : Repair the levee slope damaged by livestock and prevent large animal access.					
Inspector Comment					
Livestock damage to levee slope but the integrity of the levee is not compromised. Continue to monitor.

Looking southwest at the landside slope.

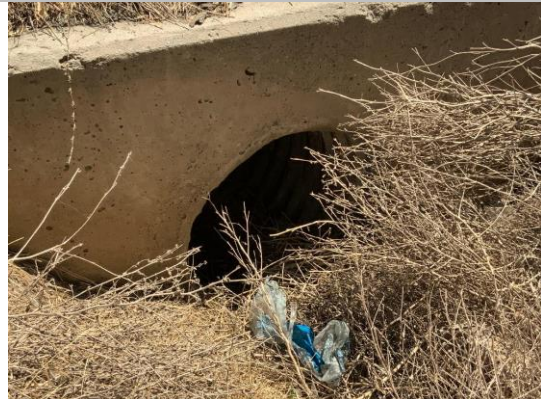
Photo 1 of 2 : UCIP_SP_2024_71116_102250.jpg

Comment Code						
Inspector Comment						
DS_ID:19870 FS_ID:71116 EP_NO: N/A Repair Type: No Action Needed EVAL Issue: Crossing Status: Found UCIP Comments: 09/18/2023 Record updated from Non-Urgent to No Action Needed. Pipe was CIPP lined. DMP internal video inspection has found none or minor pipe defects. Recommend next video inspection in 5 years. (O. Yakimov - DWR UCIP) 07/13/2021 Record remains Non-Urgent. DWR DMP internal inspection has found pipe integrity issues. LOF of crossing is greater than or equal to 4.1 and less than 5. Crossing will be monitored until funding becomes available for rehabilitation. Some vegetation buildup over LS pipe inlet and WS flapgate, recommend removal of vegetation on both ends. No permit was found authorizing this encroachment. CVFPB will need to review crossing to determine owner. The UCIP inspection was completed with GEI staff, P. Espinoza. (H. Dunn – GEI) 04/18/2014 Sediment buildup in pipe--recommend contacting owner to clear sediment. (O. Magana - DWR UCIP) FIELD_STRUCT_DESC: 24-inch CIPP-lined corrugated metal gravity drainage pipe (CMP) through the levee, 16.5 feet below the crown. Flap gate on the waterside (WS) end. Concrete headwall on each end. [Additional Reference(s): DWR Levee Log, 2002, (HLM 8.22). USACE San Joaquin O&M Manual, Unit No. 601, Part No. 1, 1967, Amended in 1978, Revised 20 June 1985, (HLM 8.21). DWR As-Built Specification No. 61-01, Sheet No. 51, 7 March 1961, (HLM 8.21)]. FS Date: 7/13/2021

LS view: Closeup of pipe inlet at toe. Some vegetation blocking.

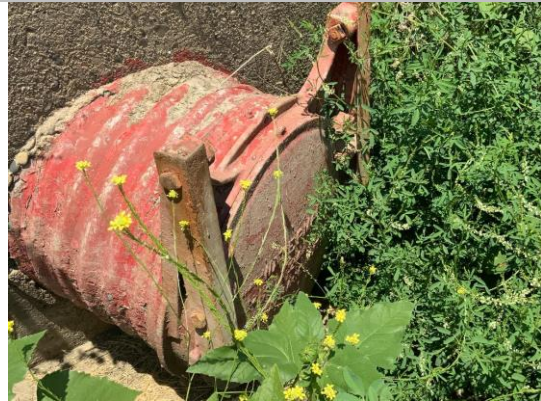
Photo 2 of 2 : UCIP_SP_2024_71116_102246.jpg

LM Start	8.13	Rating **	A	Issue No.	1234 (cont)
LM End	8.13	Issue Type +	Ma	Location *	
Category	Supplemental			GPS Latitude/Longitude	
				Start	End
Item	DWR UCIP LMA Responsibility			37.216547°	37.216547°
				-120.713000°	-120.713000°
DWR ID	19870

WS view: Closeup of flapgate at toe.

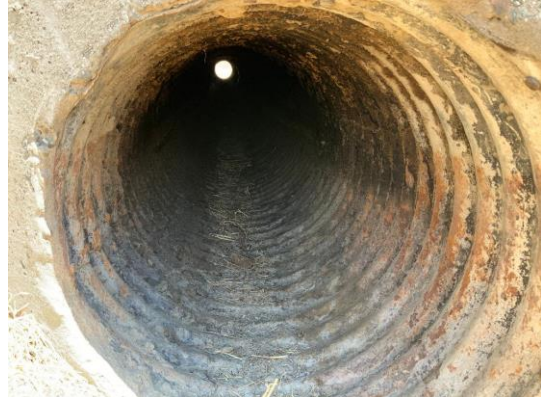
Photo 1 of 2 : UCIP_SP_2024_71117_102257.jpg

DS_ID:19871
 FS_ID:71117
 EP_NO: N/A
 Repair Type: No Action Needed
 EVAL Issue:
 Crossing Status: Found
 UCIP Comments: 09/18/2023 Record updated from Non-Urgent to No Action Needed. Pipe was CIPP lined. DMP internal video inspection has found none or minor pipe defects. Recommend next video inspection in 5 years. (O. Yakimov - DWR UCIP)
 07/13/2021 Record remains Non-Urgent. DWR DMP internal inspection has found pipe integrity issues. LOF of crossing is between 4.1 and 5. Crossing will be monitored until funding becomes available for rehabilitation. Inside of LS pipe inlet is rusted but no visible holes or deterioration. No permit was found authorizing this encroachment. CVFPB will need to review crossing to determine owner. The UCIP inspection was completed with GEI staff, P. Espinoza. (H. Dunn – GEI)

04/18/2014 Need to contact owner. Sediment buildup in pipe visible on landward side--recommend clearing. Good candidate for pressure test or video inspection due to signs of heavy corrosion. If no leaks after tests this crossing would be a good candidate for rehabilitation. (O. Magana - DWR UCIP)
 FIELD_STRUCT_DESC: 24-inch CIPP-lined corrugated metal gravity drainage pipe (CMP) through the levee, 9.2 feet below the crown. Flap gate on the waterside (WS) end. Concrete headwall on each end.
 [Additional Reference(s): DWR Levee Log, 2002, (HLM 8.51). USACE San Joaquin O&M Manual, Unit No. 601, Part No. 1, 1967, Amended in 1978, Revised 20 June 1985, (HLM 8.51). DWR As-Built Specification No. 61-01, Sheet No. 51, 7 March 1961, (HLM 8.51)].
 FS Date: 7/13/2021

LS view: Inside pipe inlet at toe, slightly rusted inside.

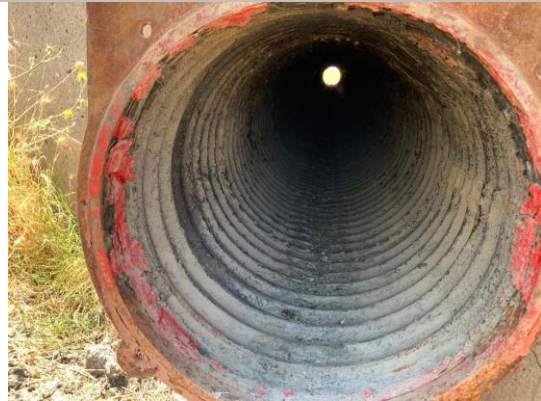
Photo 2 of 2 : UCIP_SP_2024_71117_102253.jpg

LM Start	8.43	Rating **	A	Issue No.	1235 (cont)
LM End	8.43	Issue Type +	Ma	Location *	
Category	Supplemental		GPS Latitude/Longitude		
			Start	End	
Item	DWR UCIP LMA Responsibility		37.213288°	37.213288°	
			-120.709503°	-120.709503°	
DWR ID	19871

WS view: Inside pipe outlet at toe.

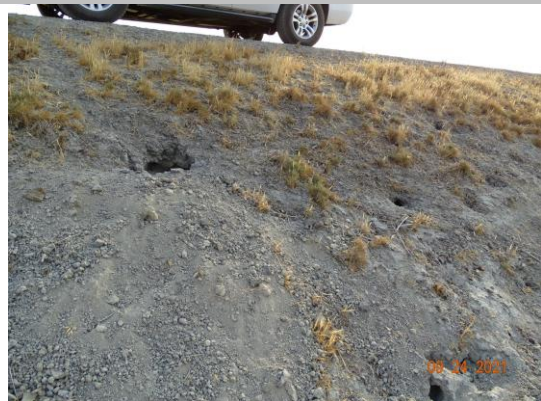
Photo 1 of 1 : SP_2024_NA0010_124_121_20240212_00044.jpg

LM Start	8.61	Rating **	A/W	Issue No.	121
LM End	8.69	Issue Type +	Ma	Location *	LS
Category	Earthen Levee			GPS Latitude/Longitude	
				Start	End
Item	Animal Control			37.211700°	37.210809°
				-120.706976°	-120.706106°
DWR ID	DWR_NA0010_06_f_2021_121				
Comment Code					
A1 : Exterminate rodents and backfill and compact or grout burrows.					
Inspector Comment

Looking at rodent holes in the landside slope. (Fall 2021)

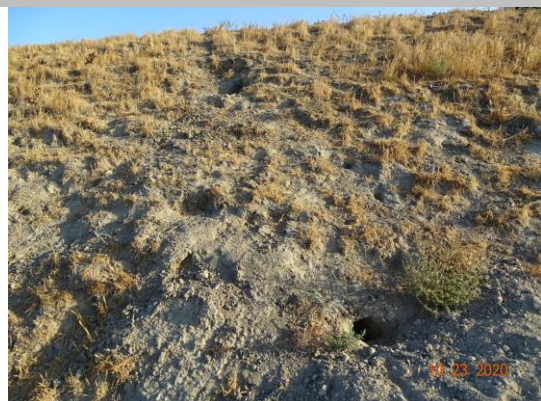
Photo 1 of 1 : SP_2024_NA0010_124_103_20240212_00031.jpg

LM Start	9.67	Rating **	M	Issue No.	103
LM End	9.71	Issue Type +	Ma	Location *	LS
Category	Earthen Levee			GPS Latitude/Longitude	
				Start	End
Item	Animal Control			37.200934°	37.200836°
				-120.694084°	-120.693406°
DWR ID	DWR_NA0010_06_f_2020_103				
Comment Code					
A1 : Exterminate rodents and backfill and compact or grout burrows.					
Inspector Comment

Rodent holes in the landside slope. (Fall 2020)

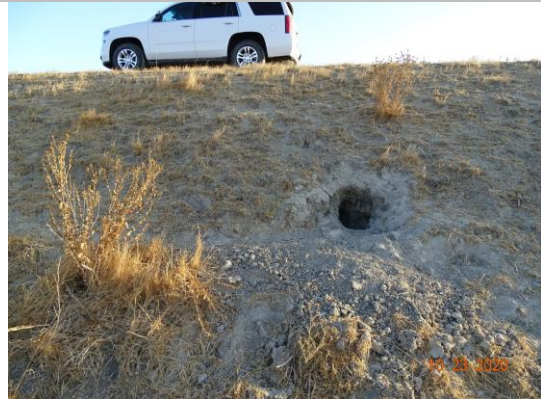
Photo 1 of 1 : SP_2024_NA0010_124_102_20240212_00030.jpg

LM Start	10.12	Rating **	U	Issue No.	102
LM End	10.12	Issue Type +	Ma	Location *	LS
Category	Earthen Levee			GPS Latitude/Longitude	
				Start	End
Item	Animal Control			37.196845°	37.196845°
				-120.687892°	-120.687892°
DWR ID	DWR_NA0010_06_f_2020_102				
Comment Code					
A3 : No rodents visible, but rodent burrows visible; need to backfill and compact or grout burrows.					
Inspector Comment

View of large animal burrow in the landside slope. (Fall 2020)

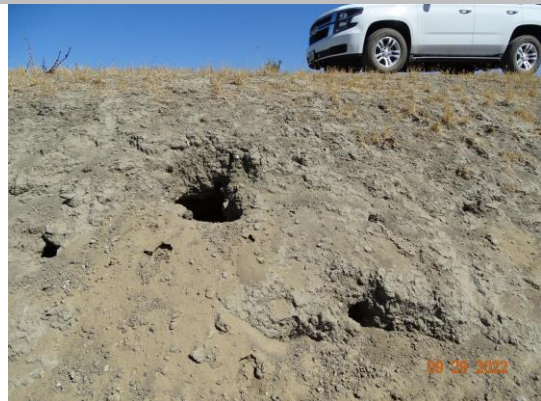
Photo 1 of 1 : SP_2024_NA0010_124_156_20240212_00069.jpg

LM Start	10.78	Rating **	U	Issue No.	156
LM End	10.78	Issue Type +	Ma	Location *	LS
Category	Earthen Levee			GPS Latitude/Longitude	
				Start	End
Item	Animal Control			37.189849°	37.189849°
				-120.679749°	-120.679749°
DWR ID	DWR_NA0010_06_f_2022_156				
Comment Code					
A3 : No rodents visible, but rodent burrows visible; need to backfill and compact or grout burrows.					
Inspector Comment					
Several rodent holes in the landside slope and landside access ramp.

Representative view of animal burrows on the landside slope. (Fall 2022)
