Flood Control Project Maintenance
Levee Inspections
LMA District Cover Sheet

Lower San Joaquin Levee District

**Flood Control Project Maintenance
Levee Inspections
Unit Cover Sheet**

Levee Inspection Report By Mile - Spring 2024

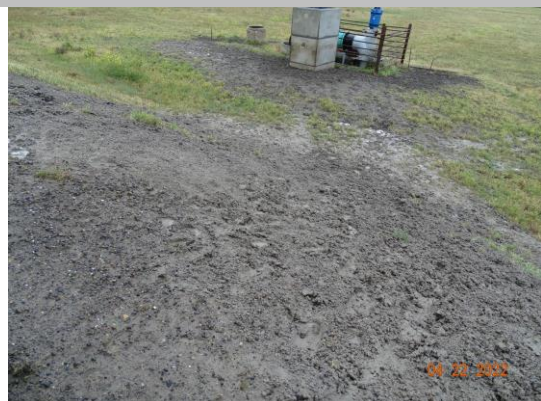
Photo 1 of 1 : SP_2024_NA0010_124_141_20240212_00059.jpg

LM Start	10.96	Rating **	A/W	Issue No.	141
LM End	10.96	Issue Type +	Ma	Location *	LS
Category	Earthen Levee			GPS Latitude/Longitude	
				Start	End
Item	Erosion / Livestock			37.187999°	37.187999°
				-120.677522°	-120.677522°
DWR ID	DWR_NA0010_06_s_2022_141				
Comment Code					
E4 : Repair the levee slope damaged by livestock and prevent large animal access.					
Inspector Comment

View of damage to the landside slope. (Spring 2022)

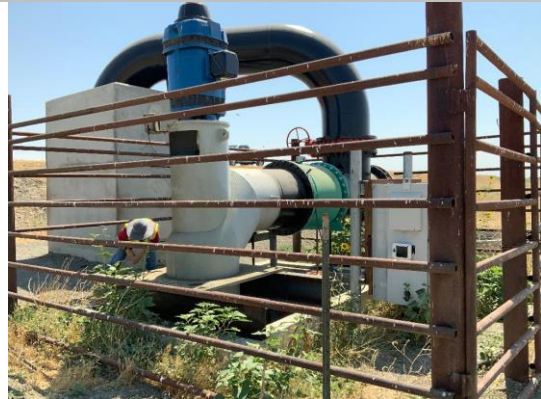
Photo 1 of 1 : UCIP_SP_2024_71128_102319.jpg

Comment Code						
Inspector Comment						
DS_ID:19563 FS_ID:71128 EP_NO: 18624 Repair Type: Non-Urgent EVAL Issue: 10, Unauthorized Modification or Non-Compliant Permit Crossing Status: Found UCIP Comments: 07/13/2021 The record has been upgraded from No Action Needed to Non-Urgent. WS outlets were underwater at time of inspection, limited inspection. There appears to be a new pump and pipe system off the LS toe. Confirm with owner on the status of this crossing. The UCIP inspection was completed with GEI staff, P. Espinoza. (H. Dunn – GEI) FIELD_STRUCT_DESC: 36-inch reinforced concrete water supply pipe (RCP) through the levee, 5.0 feet below the crown. Pipe riser units on both the inlet and the outlet sides. Control gate on the landside (LS). Slide gate on the waterside (WS) end. Joints secured in hoop steel and encased in concrete at each levee toe. (36-inch water pipe authorized under Permit No. 18624, 2010 - Wolfsen Land and Cattle Company). FS Date: 7/13/2021

LS view: New pump and pipe system off the toe.

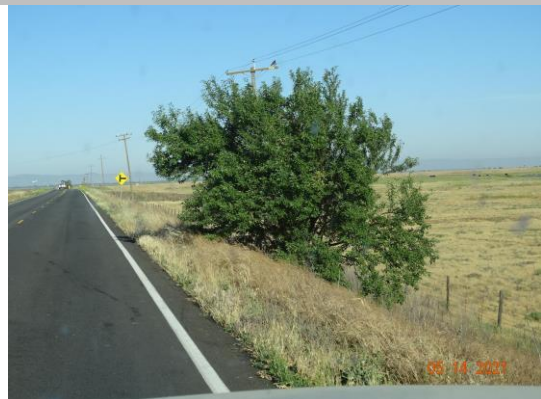
Photo 1 of 1 : SP_2024_NA0010_124_14_20240212_00007.jpg

LM Start	11.49	Rating **	M	Issue No.	14
LM End	11.49	Issue Type +	Ma	Location *	WS
Category	Earthen Levee			GPS Latitude/Longitude	
				Start	End
Item	Trim / Thin Trees			37.186189°	37.186189°
				-120.668476°	-120.668476°
DWR ID	DWR_NA0010_06_s_2015_14				
Comment Code					
T1 : Trim and thin trees to at least five feet above ground level to allow visibility of the ground and room to flood fight.					
Inspector Comment					
Almond tree located along Sandy Mush Road on waterside slope.

Looking west at tree on waterward slope. (Spring 2021)

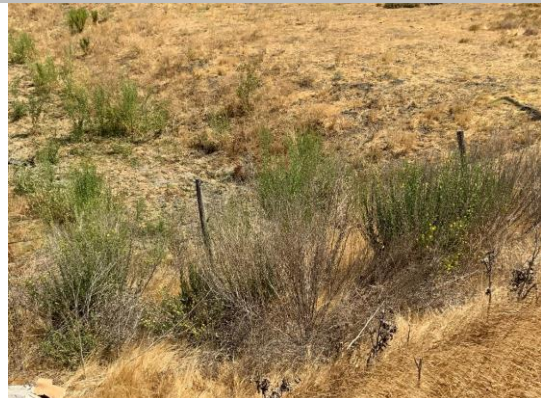
Photo 2 of 2 : UCIP_SP_2024_71150_102323.jpg

WS view: Lower slope, flapgate covered by barbed wire and dense vegetation.

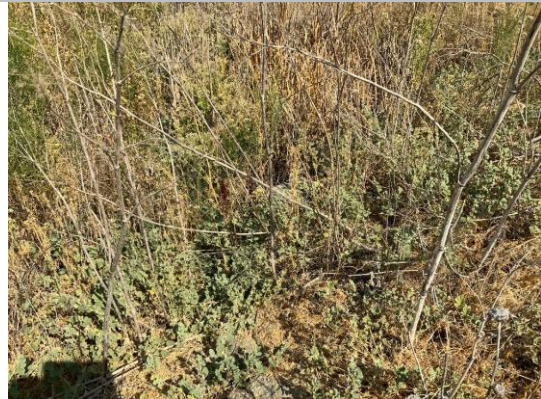
Photo 1 of 2 : UCIP_SP_2024_81022_102328.jpg

DS_ID:19876
FS_ID:81022
EP_NO: N/A
Repair Type: Urgent
EVAL Issue: 1, Pipe Integrity
Crossing Status: Found
UCIP Comments: 09/19/2023 Record updated from Non-Urgent to Urgent. DMP internal video inspection has found severe pipe defects. Crossing will be monitored until funding becomes available to address the issues. (O. Yakimov - DWR UCIP)
07/13/2021 The record remains Non-Urgent. Dense vegetation over LS inlet and WS outlet, recommend removal of vegetation from both sides. Limited inspection of both inlet and outlet. No permit was found authorizing this encroachment. CVFPB will need to review crossing to determine owner. The UCIP inspection was completed with GEI staff, P. Espinoza. (H. Dunn – GEI) 04/17/2014 Clear debris from waterward and landward toes. (O. Magana - DWR UCIP)
FIELD_STRUCT_DESC: 36-inch corrugated metal gravity drainage pipe (CMP) through the levee, 17.0 feet below the crown. Slide gate in a pipe riser unit on the waterside (WS) slope. [Additional Reference(s): DWR Levee Log, 2002, (HLM 11.83). USACE San Joaquin O&M Manual, Unit No. 601, Part No. 1, 1967, Amended in 1978, Revised 20 June 1985, (HLM 11.82). DWR As-Built Specification No. 59-01, Sheet No. 66, 10 December 1958, (HLM 11.82)].

LM Start	11.74	Rating **	U	Issue No.	1238 (cont)
LM End	11.74	Issue Type +	Ma	Location *

WS view: Flapgate barely visible under dense vegetation at toe.

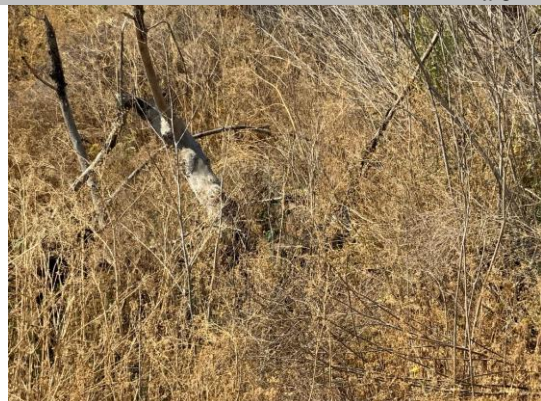
Photo 2 of 2 : UCIP_SP_2024_81022_102333.jpg

LS view: Headwall and inlet covered by dense vegetation at toe.

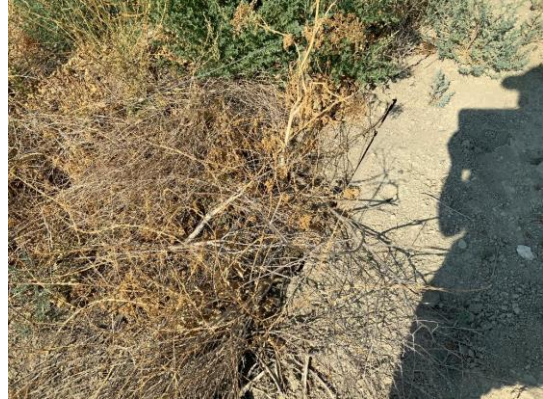
Photo 1 of 3 : UCIP_SP_2024_71152_102340.jpg

Comment Code					
Inspector Comment					
DS_ID:19877 FS_ID:71152 EP_NO: N/A Repair Type: Non-Urgent EVAL Issue: 4b, Safety Issue Crossing Status: Found UCIP Comments: 07/13/2021 The record remains Non-Urgent. Partial cover on WS riser, recommend repair for safety reasons. Limited inspection due to LS pipe inlet being overed with vegetation, headwall barely visible, recommend removal. WS outlet not found, possibly buried under dirt or vegetaion. Recommend removal of vegetation and dirt to uncover WS pipe outlet. No permit was found authorizing this encroachment. CVFPB will need to review crossing to determine owner. The UCIP inspection was completed with GEI staff, P. Espinoza. (H. Dunn – GEI) 04/17/2014 Not accessible--crossing is buried on landward side. Need to contact owner to determine status. (O. Magana - DWR UCIP) FIELD_STRUCT_DESC: 24-inch corrugated metal gravity drainage pipe (CMP) through the levee, 10.8 feet below the crown. Flap gate on the waterside (WS) end. [Additional Reference(s): DWR Levee Log, 2002, (HLM 13.31). USACE San Joaquin O&M Manual, Unit No. 601, Part No. 1, 1967, Amended in 1978, Revised 20 June 1985, (HLM 13.30). DWR As-Built Specification No. 59-01, Sheet No. 67, 10 December 1958, (HLM 13.30)]. FS Date: 7/13/2021

LS view: Top of headwall at toe, inlet covered with vegetation.

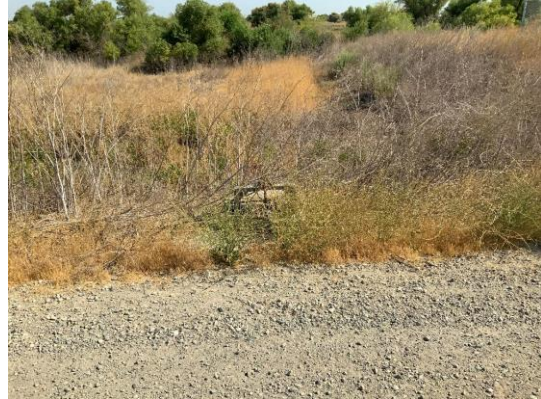
Photo 3 of 3 : UCIP_SP_2024_71152_102336.jpg

LM Start	13.22	Rating **	M	Issue No.	1239 (cont)
LM End	13.22	Issue Type +	Ma	Location *	
Category	Supplemental			GPS Latitude/Longitude	
				Start	End
Item	DWR UCIP LMA Responsibility			37.171675°	37.171675°
				-120.655064°	-120.655064°
DWR ID	19877

WS view: Riser visible on slope from crown.

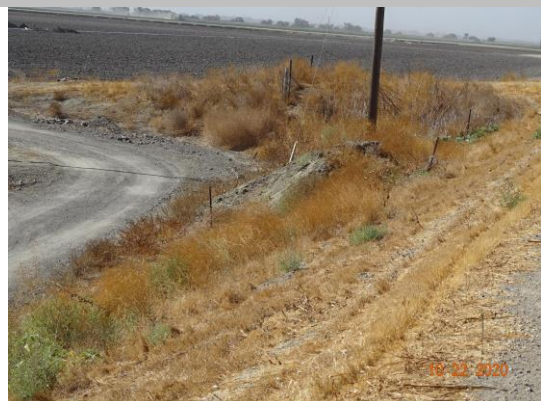
Photo 1 of 1 : SP_2024_NA0010_124_68_20240212_00012.jpg

LM Start	13.24	Rating **	M	Issue No.	68
LM End	13.24	Issue Type +	En	Location *	LS
Category	Earthen Levee			GPS Latitude/Longitude	
				Start	End
Item	Encroachments			37.171686°	37.171686°
				-120.654562°	-120.654562°
DWR ID	DWR_NA0010_06_f_2015_68				
Comment Code					
MA : Material					
Inspector Comment					
Landowner stockpiled dirt at landside toe.

Looking downstream at dirt stockpile on the landside toe. (Fall 2020)

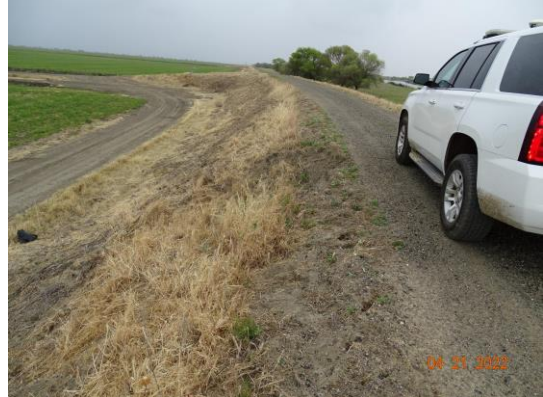
Photo 1 of 1 : SP_2024_NA0010_124_120_20240212_00043.jpg

LM Start	14.00	Rating **	U	Issue No.	120
LM End	14.00	Issue Type +	Ma	Location *	LS
Category	Earthen Levee			GPS Latitude/Longitude	
				Start	End
Item	Slope Stability			37.171591°	37.171591°
				-120.640938°	-120.640938°
DWR ID	DWR_NA0010_06_f_2021_120				
Comment Code					
S1 : Repair slope instability.					
Inspector Comment					
Caving has eaten approximately 1 foot into the levee crown.

View of slope stability issue on the landside slope. (Spring 2022)

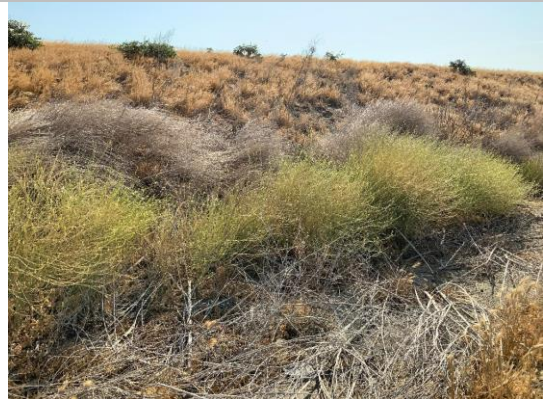
Photo 1 of 1 : UCIP_SP_2024_71153_102397.jpg

LM Start	14.36	Rating **	M	Issue No.	1240
LM End	14.36	Issue Type +	Ma	Location *	
Category	Supplemental			GPS Latitude/Longitude	
				Start	End
Item	DWR UCIP LMA Responsibility			37.167888°	37.167888°
				-120.636419°	-120.636419°
DWR ID	19878

Comment Code					
Inspector Comment					
DS_ID:19878 FS_ID:71153 EP_NO: N/A Repair Type: Non-Urgent EVAL Issue: 11, Maintenance Compliance Issue Crossing Status: Found UCIP Comments: 07/13/2021 The record remains Non-Urgent. Limited inspection due to LS pipe inlet not being found, assuming its completely buried. Recommend removing dirt and vegetation to find alignment and confirming with owner on the status of this pipe. No permit was found authorizing this encroachment. CVFPB will need to review crossing to determine owner. The UCIP inspection was completed with GEI staff, P. Espinoza. (H. Dunn – GEI) 04/17/2014 Not accessible--crossing is buried on landward side. Need to contact owner to determine status. (O. Magana - DWR UCIP) FIELD_STRUCT_DESC: 24-inch corrugated metal gravity drainage pipe (CMP) through the levee, 12.3 feet below the crown. Flap gate on the waterside (WS) end. [Additional Reference(s): DWR Levee Log, 2002 (HLM 14.45). USACE San Joaquin O&M Manual, Unit No. 601, Part No. 1, 1967, Amended in 1978, Revised 20 June 1985, (HLM 14.44). DWR As-Built Specification No. 59-01, Sheet No. 68, 10 December 1958, (HLM 14.44)]. FS Date: 7/13/2021

LS view: Slope from toe, no pipe visible.

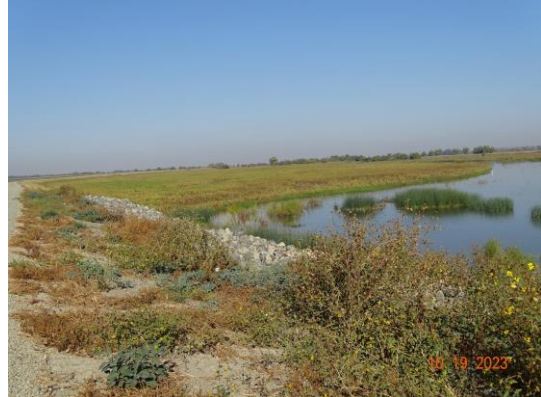
Photo 1 of 1 : SP_2024_NA0010_124_144_20240212_00062.jpg

LM Start	14.93	Rating **	A/W	Issue No.	144
LM End	15.00	Issue Type +	Ma	Location *	WS
Category	Earthen Levee			GPS Latitude/Longitude	
				Start	End
Item	Riprap Revetments			37.162295°	37.161858°
				-120.628897°	-120.627784°
DWR ID	DWR_NA0010_06_f_2023_144				
Comment Code					
RR : Riprap Revetments					
Inspector Comment

View of revetment protected waterside slope. (Fall 2023)

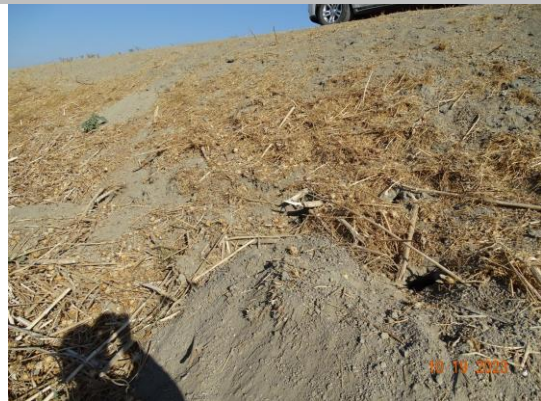
Photo 1 of 1 : SP_2024_NA0010_124_134_20240212_00052.jpg

LM Start	15.12	Rating **	U	Issue No.	134
LM End	15.12	Issue Type +	Ma	Location *	LS
Category	Earthen Levee			GPS Latitude/Longitude	
				Start	End
Item	Animal Control			37.161098°	37.161098°
				-120.625870°	-120.625870°
DWR ID	DWR_NA0010_06_f_2023_134				
Comment Code					
A3 : No rodents visible, but rodent burrows visible; need to backfill and compact or grout burrows.					
Inspector Comment

View of several rodent burrows in the landside slope. (Fall 2023)

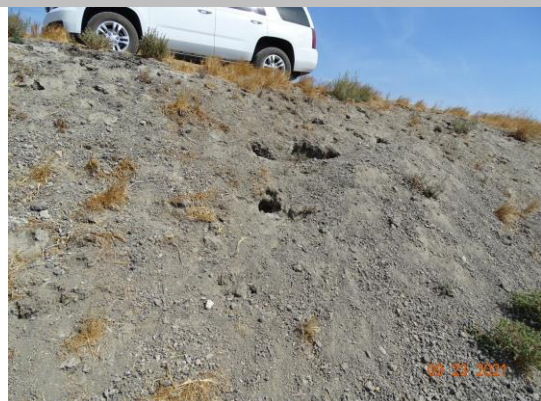
Photo 1 of 1 : SP_2024_NA0010_124_124_20240212_00046.jpg

LM Start	15.28	Rating **	U	Issue No.	124
LM End	15.61	Issue Type +	Ma	Location *	LS
Category	Earthen Levee			GPS Latitude/Longitude	
				Start	End
Item	Animal Control			37.160104°	37.157640°
				-120.623317°	-120.618180°
DWR ID	DWR_NA0010_06_s_2012_124				
Comment Code					
A1 : Exterminate rodents and backfill and compact or grout burrows.					
Inspector Comment

Large rodent burrows observed in the landside slope. (Fall 2021)

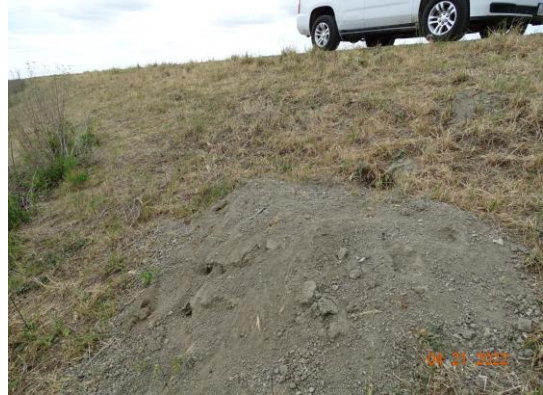
Photo 1 of 1 : SP_2024_NA0010_124_118_20240212_00041.jpg

LM Start	15.32	Rating **	M	Issue No.	118
LM End	15.32	Issue Type +	Ma	Location *	WS
Category	Earthen Levee			GPS Latitude/Longitude	
				Start	End
Item	Animal Control			37.159815°	37.159815°
				-120.622513°	-120.622513°
DWR ID	DWR_NA0010_06_s_2022_118				
Comment Code					
A1 : Exterminate rodents and backfill and compact or grout burrows.					
Inspector Comment

View of rodent holes on the waterside slope. (Spring 2022)

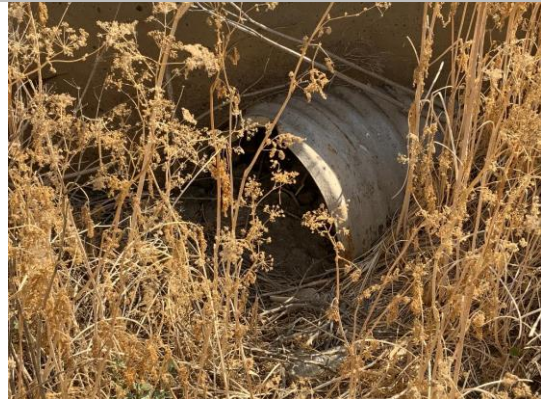
Photo 1 of 2 : UCIP_SP_2024_77870_102351.jpg

Comment Code						
Inspector Comment						
DS_ID:19884 FS_ID:77870 EP_NO: N/A Repair Type: Urgent EVAL Issue: 1, Pipe Integrity Crossing Status: Found UCIP Comments: 12/14/2022 Record updated from Non-Urgent to Urgent. DMP internal video inspection has found pipe integrity issues. LOF of crossing is between 5 and 6. Crossing will be monitored until funding becomes available to address the issues. (O.Yakimov - DWR UCIP) 07/13/2021 The record remains Non-Urgent. Limited inspection of LS pipe inlet. LS pipe edges are warped and inlet filled with sediment and some vegetation, recommend cleaning out. No permit was found authorizing this encroachment. CVFPB will need to review crossing to determine owner. The UCIP inspection was completed with GEI staff, P. Espinoza. (H. Dunn – GEI) 04/17/2014 Need to contact owner. Sediment buildup on both the waterward and landward side. Recommend removing sediment buildup from both side. Also recommend clearing excess sediment inside crossing. (O. Magana - DWR UCIP) FIELD_STRUCT_DESC: 24-inch corrugated metal gravity drainage pipe (CMP) through the levee, 14.0 feet below the crown. Flap gate on the waterside (WS) end. [Additional Reference(s): DWR Levee Log, 2002, (HLM 15.78). USACE San Joaquin O&M Manual, Unit No. 601, Part No. 1, 1967, Amended in 1978, Revised 20 June 1985, (HLM 15.76). DWR As-Built Specification No. 59-01, Sheet No. 69, 10 December 1958, (HLM 15.76)]. FS Date: 7/13/2021 2:03:17 PM

LS view: Closeup of pipe inlet at toe with sediment buildup.

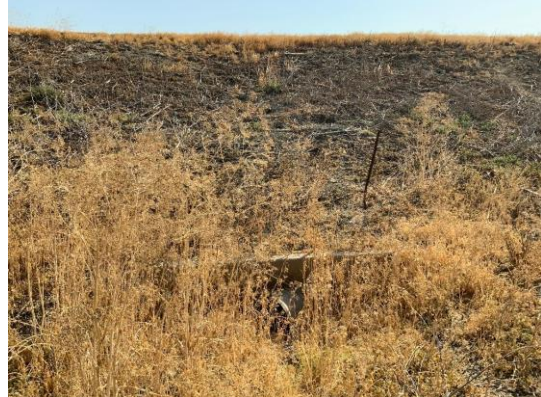
Photo 2 of 2 : UCIP_SP_2024_77870_102350.jpg

LS view: Headwall visible at toe.

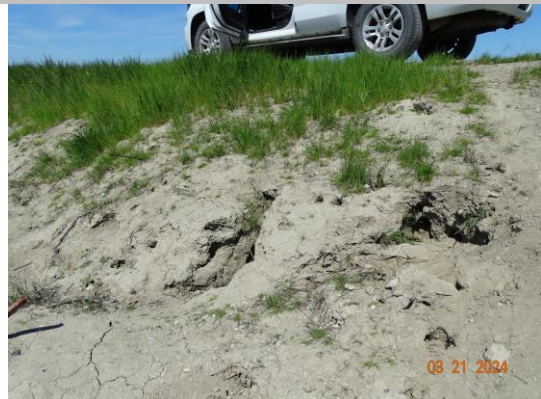
Photo 1 of 1 : SP_2024_NA0010_124_56_20240326_00153.jpg

LM Start	15.68	Rating **	M	Issue No.	56
LM End	15.68	Issue Type +	Ma	Location *	LS
Category	Earthen Levee			GPS Latitude/Longitude	
				Start	End
Item	Animal Control			37.156889°	37.156889°
				-120.617165°	-120.617165°
DWR ID	DWR_NA0010_06_s_2024_56				
Comment Code					
A3 : No rodents visible, but rodent burrows visible; need to backfill and compact or grout burrows.					
Inspector Comment

View of rodent burrows on the landside slope. (Spring 2024)

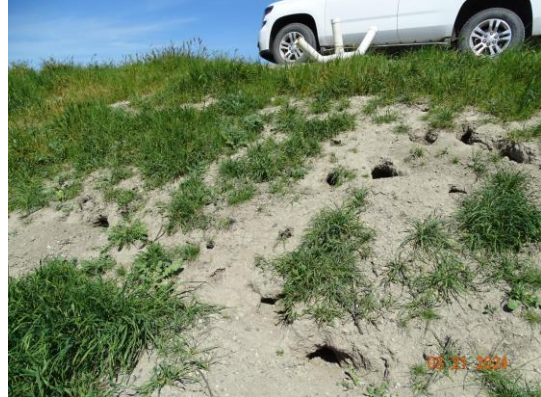
Photo 1 of 1 : SP_2024_NA0010_124_54_20240326_00154.jpg

LM Start	16.33	Rating **	M	Issue No.	54
LM End	16.33	Issue Type +	Ma	Location *	LS
Category	Earthen Levee			GPS Latitude/Longitude	
				Start	End
Item	Animal Control			37.150606°	37.150606°
				-120.608552°	-120.608552°
DWR ID	DWR_NA0010_06_s_2024_54				
Comment Code					
A3 : No rodents visible, but rodent burrows visible; need to backfill and compact or grout burrows.					
Inspector Comment					
LMA has placed bait stations along this section.

Several rodent burrows observed along this section. (Spring 2024)

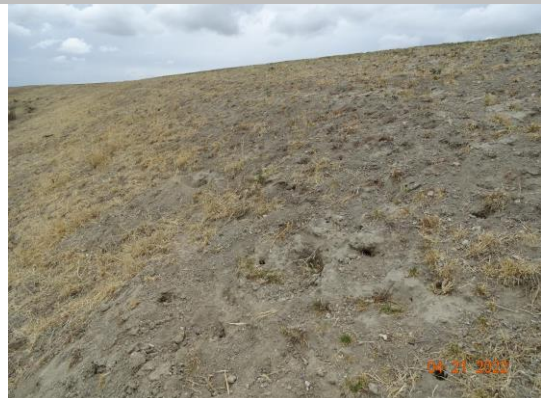
Photo 1 of 1 : SP_2024_NA0010_124_115_20240212_00039.jpg

LM Start	17.10	Rating **	M	Issue No.	115
LM End	17.13	Issue Type +	Ma	Location *	LS
Category	Earthen Levee			GPS Latitude/Longitude	
				Start	End
Item	Animal Control			37.141678°	37.141305°
				-120.600221°	-120.599949°
DWR ID	DWR_NA0010_06_f_2021_115				
Comment Code					
A1 : Exterminate rodents and backfill and compact or grout burrows.					
Inspector Comment

Looking along the landside slope at rodent burrows. (Spring 2022)

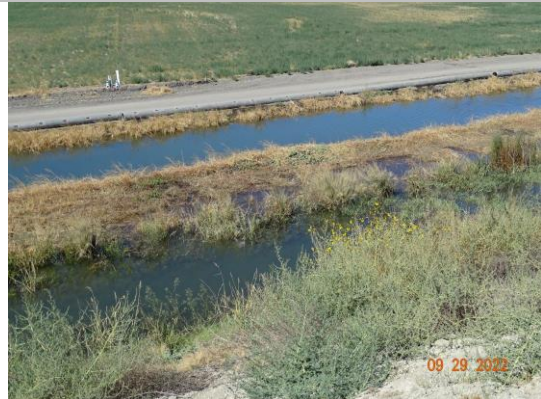
Photo 1 of 1 : SP_2024_NA0010_124_153_20240212_00068.jpg

LM Start	17.79	Rating **	A/W	Issue No.	153
LM End	18.77	Issue Type +	En	Location *	LS
Category	Earthen Levee			GPS Latitude/Longitude	
				Start	End
Item	Encroachments			37.133023°	37.119876°
				-120.593812°	-120.587457°
DWR ID	DWR_NA0010_06_f_2022_153				
Comment Code					
DT : Ditch					
Inspector Comment					
The ditch is located outside of the easement but water appeared to be seeping through the ditch walls and causing water to pool on the landside toe.

Seepage on the landside toe from the nearby ditch. (Fall 2022)

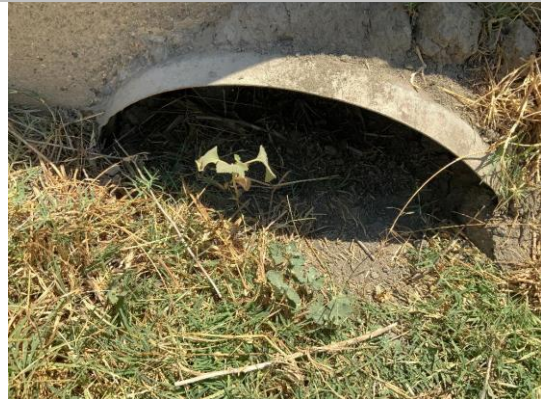
Photo 1 of 2 : UCIP_SP_2024_77871_101421.jpg

Comment Code						
Inspector Comment						
DS_ID:19887 FS_ID:77871 EP_NO: N/A Repair Type: Urgent EVAL Issue: 1, Pipe Integrity Crossing Status: Found UCIP Comments: 12/14/2022 Record updated from Non-Urgent to Urgent. DMP internal video inspection has found pipe integrity issues. LOF of crossing is between 5 and 6. Crossing will be monitored until funding becomes available to address the issues. (O.Yakimov - DWR UCIP) 07/12/2021 The record remains Non-Urgent. LS pipe inlet filled with sediment, recommend removal. WS flapgate has some vegetation over it, recommend removal. Limited inspection on both WS and LS. No permit was found authorizing this encroachment. CVFPB will need to review crossing to determine owner. The UCIP inspection was completed with GEI staff, P. Espinoza. (H. Dunn – GEI) 04/17/2014 Sediment build up on landward side toe -- debris blockage. No photos available. Recommend taking photos of crossing. (O. Magana - DWR UCIP) FIELD_STRUCT_DESC: 24-inch corrugated metal gravity drainage pipe (CMP) through the levee, 11.5 feet below the crown. Flap gate on the waterside (WS) end. [Additional Reference(s): DWR Levee Log, 2002, (HLM 18.29). USACE San Joaquin O&M Manual, Unit No. 601, Part No. 1, 1967, Amended in 1978, Revised 20 June 1985, (HLM 18.27). DWR As-Built Specification No. 59-01, Sheet No. 70, 10 December 1958, (HLM 18.27)]. FS Date: 7/13/2021 2:03:37 PM

LS view: Closeup of pipe inlet at toe filled with sediment.

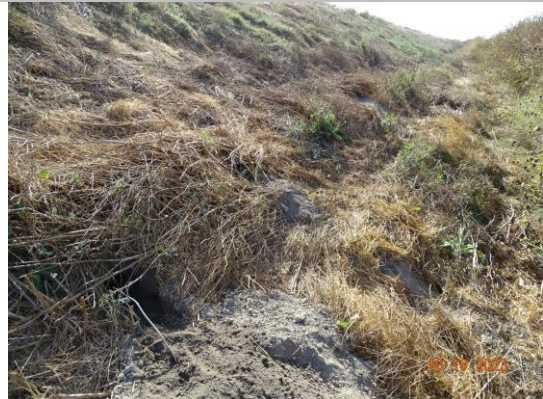
Photo 1 of 1 : SP_2024_NA0010_124_128_20240212_00048.jpg

LM Start	18.70	Rating **	M	Issue No.	128
LM End	18.70	Issue Type +	Ma	Location *	LS
Category	Earthen Levee			GPS Latitude/Longitude	
				Start	End
Item	Animal Control			37.120792°	37.120792°
				-120.587878°	-120.587878°
DWR ID	DWR_NA0010_06_f_2023_128				
Comment Code					
A3 : No rodents visible, but rodent burrows visible; need to backfill and compact or grout burrows.					
Inspector Comment

View of rodent holes along the landside slope. (Fall 2023)

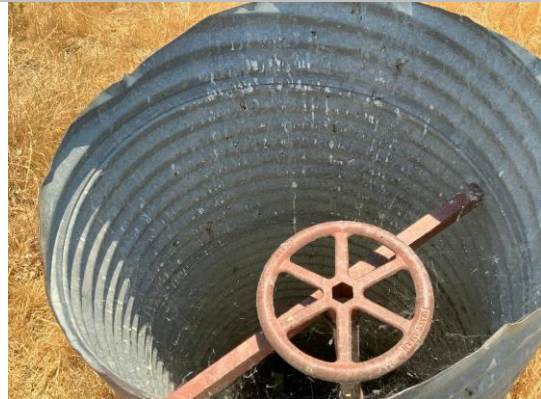
Photo 1 of 2 : UCIP_SP_2024_71139_101555.jpg

Comment Code						
Inspector Comment						
DS_ID:19889 FS_ID:71139 EP_NO: N/A Repair Type: Non-Urgent EVAL Issue: 4b, Safety Issue Crossing Status: Found UCIP Comments: 07/12/2021 The record remains Non-Urgent. Barbed wire over LS end, could not inspect closely. No cover over WS riser, causing safety hazard. Slightly warped edges on both WS and LS pipe inlet/outlet. No permit was found authorizing this encroachment. CVFPB will need to review crossing to determine owner. The UCIP inspection was completed with GEI staff, P. Espinoza. (H. Dunn – GEI) 04/17/2014 Dense vegetation limits the inspector's visibility to identify signs of pipe failure (leaks) along the landward slope. Recommend removing vegetation along pipe alignment to conduct proper inspection of structure. (O. Magana - DWR UCIP) FIELD_STRUCT_DESC: 24-inch corrugated metal gravity drainage pipe (CMP) through the levee, 10.2 feet below the crown. Slide gate in a pipe riser unit on the waterside (WS) slope. [Additional Reference(s): DWR Levee Log, 2002, (HLM 18.98). USACE San Joaquin O&M Manual, Unit No. 601, Part No. 1, 1967, Amended in 1978, Revised 20 June 1985, (HLM 18.97). DWR As-Built Specification No. 59-01, Sheet No. 71, 10 December 1958, (HLM 18.97)]. FS Date: 7/12/2021

WS view: Riser missing cover on slope.

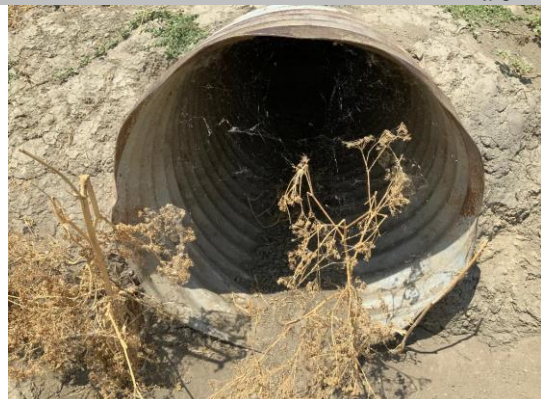
Photo 2 of 2 : UCIP_SP_2024_71139_101557.jpg

WS view: Closeup of pipe outlet at toe with slightly warped edges.

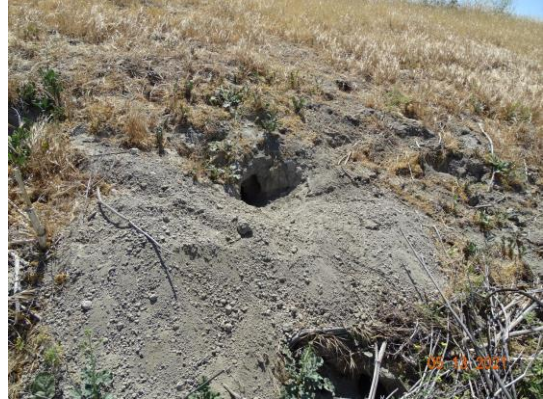
Photo 1 of 1 : SP_2024_NA0010_124_72_20240212_00015.jpg

LM Start	19.07	Rating **	U	Issue No.	72
LM End	19.07	Issue Type +	Ma	Location *	LS
Category	Earthen Levee			GPS Latitude/Longitude	
				Start	End
Item	Animal Control			37.115706°	37.115706°
				-120.587036°	-120.587036°
DWR ID	DWR_NA0010_06_s_2021_72				
Comment Code					
A1 : Exterminate rodents and backfill and compact or grout burrows.					
Inspector Comment

Large rodent burrows observed in the landside slope. (Spring 2021)

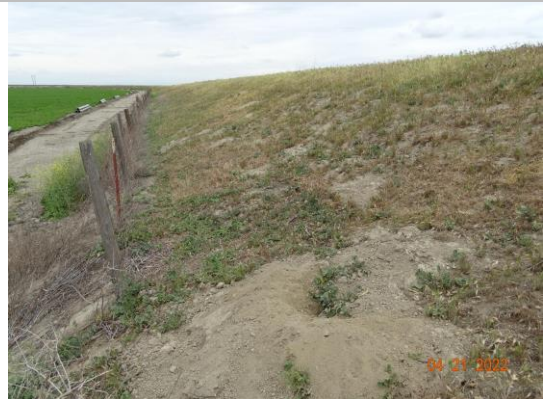
Photo 1 of 1 : SP_2024_NA0010_124_136_20240212_00054.jpg

LM Start	19.18	Rating **	M	Issue No.	136
LM End	19.22	Issue Type +	Ma	Location *	LS
Category	Earthen Levee			GPS Latitude/Longitude	
				Start	End
Item	Animal Control			37.114272°	37.113716°
				-120.587857°	-120.588225°
DWR ID	DWR_NA0010_06_s_2022_136				
Comment Code					
A3 : No rodents visible, but rodent burrows visible; need to backfill and compact or grout burrows.					
Inspector Comment

Looking downstream along the landside slope at rodent burrows. (Spring 2022)

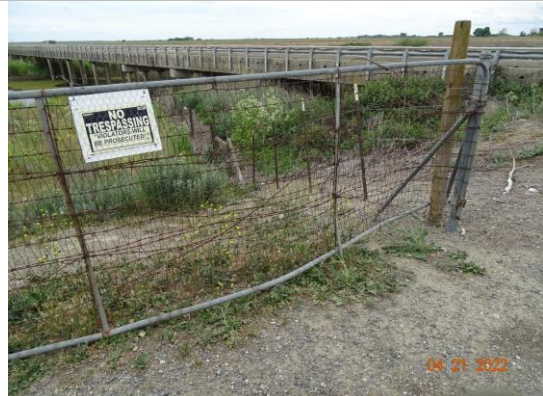
Photo 1 of 1 : SP_2024_NA0010_124_135_20240212_00053.jpg

LM Start	19.23	Rating **	M	Issue No.	135
LM End	19.23	Issue Type +	Ma	Location *	CR
Category	Earthen Levee			GPS Latitude/Longitude	
				Start	End
Item	Access Gates			37.113581°	37.113581°
				-120.588310°	-120.588310°
DWR ID	DWR_NA0010_06_s_2022_135				
Comment Code					
AG : Access Gates					
Inspector Comment					
Bottom of gate has broken off near hinge causing the gate to drag.

View of access gate with a broken bottom hinge. (Spring 2022)

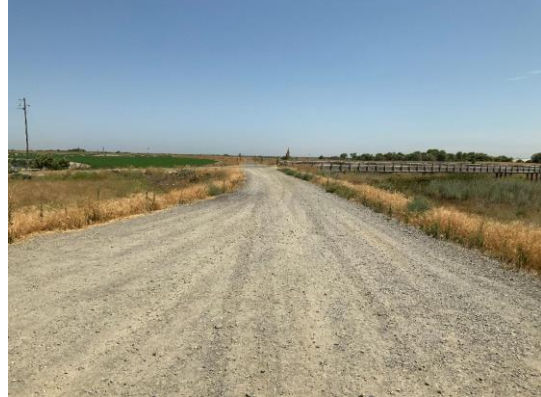
Photo 1 of 3 : UCIP_SP_2024_81021_101574.jpg

Comment Code						
Inspector Comment						
DS_ID:19890 FS_ID:81021 EP_NO: N/A Repair Type: Urgent EVAL Issue: 1, Pipe Integrity Crossing Status: Found UCIP Comments: 09/19/2023 Record updated from Non-Urgent to Urgent. DMP internal video inspection has found severe pipe defects. Crossing will be monitored until funding becomes available to address the issues. (O. Yakimov - DWR UCIP) 07/12/2021 The record remains Non-Urgent. WS pipe outlet visible but underwater, unable to inspect closely. LS pipe inlet was not seen, but likely underwater. No permit was found authorizing this encroachment. CVFPB will need to review crossing to determine owner. The UCIP inspection was completed with GEI staff, P. Espinoza. (H. Dunn – GEI) 04/17/2014 Dense vegetation limits the inspector's visibility to identify signs of pipe failure (leaks) along the slopes. Recommend removing vegetation along pipe alignment to conduct proper inspection of structure. (O. Magana - DWR UCIP) FIELD_STRUCT_DESC: 48-inch corrugated metal gravity drainage pipe (CMP) through the levee, 20.0 feet below the crown. Slide gate in a pipe riser unit on the waterside (WS) slope. Riprap along the landside (LS) slope. [Additional Reference(s): DWR Levee Log, 2002, (HLM 19.36). USACE San Joaquin O&M Manual, Unit No. 601, Part No. 1, 1967, Amended in 1978, Revised 20 June 1985, (HLM 19.36). DWR As-Built Specification No. 59-01, Sheet No. 72, 10 December 1958, (HLM 19.36)]. FS Date: 7/12/2021

Levee crown.

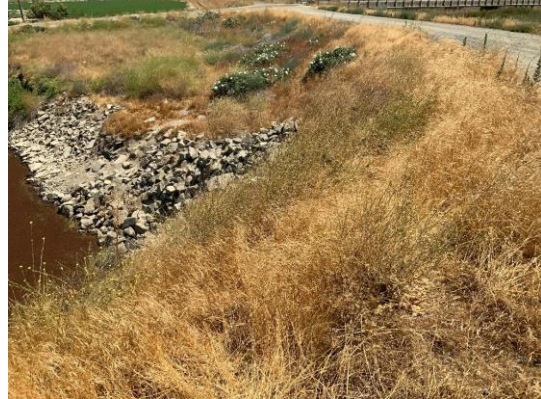
Photo 2 of 3 : UCIP_SP_2024_81021_101575.jpg

LS view: Slope from crown, no pipe visible.

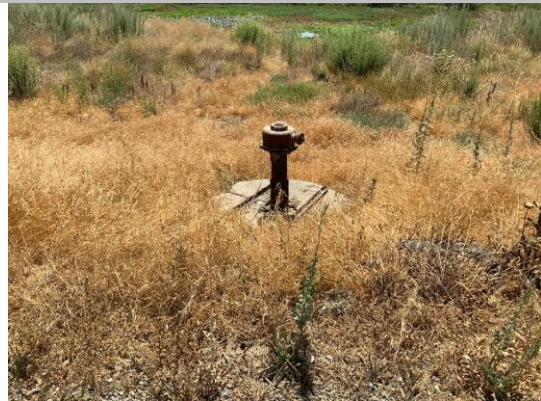
Photo 3 of 3 : UCIP_SP_2024_81021_101576.jpg

WS view: Slidegate visible on slope from crown.

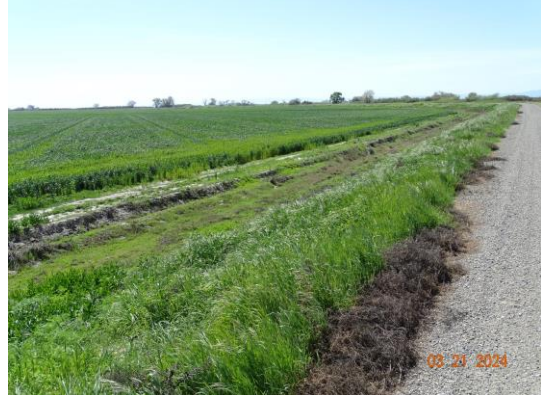
Photo 1 of 1 : SP_2024_NA0010_124_53_20240326_00155.jpg

LM Start	19.41	Rating **	M	Issue No.	53
LM End	19.51	Issue Type +	Ma	Location *	LS
Category	Earthen Levee			GPS Latitude/Longitude	
				Start	End
Item	Vegetation			37.111443°	37.113019°
				-120.587718°	-120.586566°
DWR ID	DWR_NA0010_06_s_2024_53				
Comment Code					
V1 : Control annual grass and weeds on the levee slopes and easements.					
Inspector Comment

View of vegetation on the landside slope. (Spring 2024)

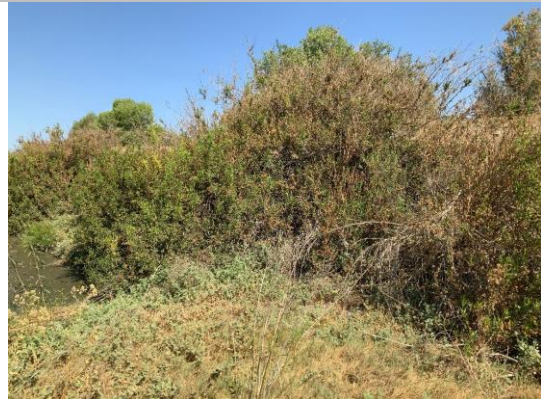
Photo 1 of 2 : UCIP_SP_2024_71141_101579.jpg

Comment Code						
Inspector Comment						
DS_ID:19891 FS_ID:71141 EP_NO: N/A Repair Type: Non-Urgent EVAL Issue: 11, Maintenance Compliance Issue Crossing Status: Found UCIP Comments: 07/12/2021 The record remains Non-Urgent. Limited inspection due to dense vegetation on LS and WS ends, LS headwall just barely visible, recommend removal of vegetation. No permit was found authorizing this encroachment. CVFPB will need to review crossing to determine owner. The UCIP inspection was completed with GEI staff, P. Espinoza. (H. Dunn – GEI) 04/17/2014 Dense vegetation limits the inspector's visibility to identify signs of pipe failure (leaks) along the slopes. Recommend removing vegetation along pipe alignment to conduct proper inspection of structure. (O. Magana - DWR UCIP) FIELD_STRUCT_DESC: 30-inch by 30-inch reinforced concrete box gravity drainage culvert (RCBC) through the levee, 14.0 feet below the crown. Flap gate on the waterside (WS) end. [Additional Reference(s): DWR Levee Log, 2002, (HLM 19.82). USACE San Joaquin O&M Manual, Unit No. 601, Part No. 1, 1967, Amended in 1978, Revised 20 June 1985, (HLM 19.85). DWR As-Built Specification No. 59-01, Sheet No. 73, 10 December 1958, (HLM 19.85)]. FS Date: 7/12/2021

LS view: Dense vegetation over pipe inlet at toe, pipe not visible.

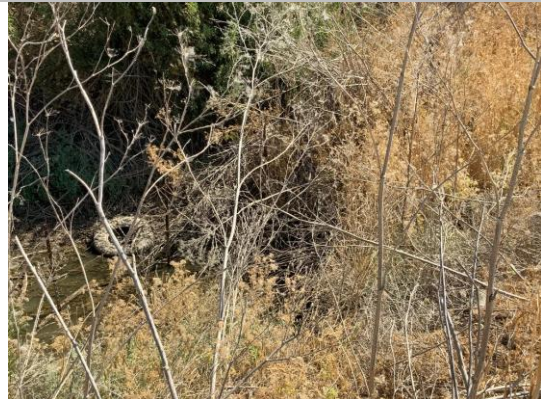
Photo 2 of 2 : UCIP_SP_2024_71141_101584.jpg

WS view: Close up of pipe outlet area covered with vegetation.

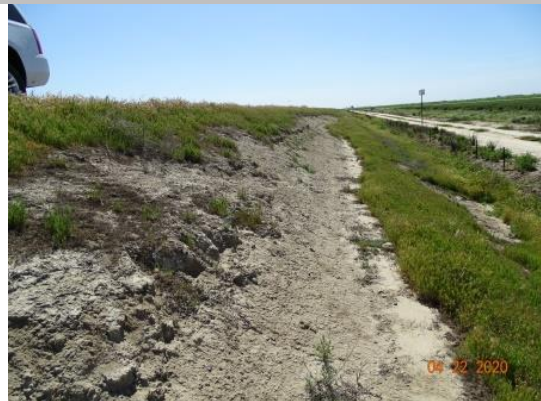
Photo 1 of 1 : SP_2024_NA0010_124_1209_20240212_00075.jpg

LM Start	20.79	Rating **	M	Issue No.	1209
LM End	21.19	Issue Type +	Ma	Location *	LS
Category	Earthen Levee			GPS Latitude/Longitude	
				Start	End
Item	Erosion / Livestock			37.113107°	37.108653°
				-120.563782°	-120.558977°
DWR ID	DWR_NA0010_06_s_2015_1209				
Comment Code					
E4 : Repair the levee slope damaged by livestock and prevent large animal access.					
Inspector Comment					
Erosion on landside slope greater than 3 inches. Erosion caused by livestock.

Erosion on the landside slope from livestock activity. (Spring 2020)

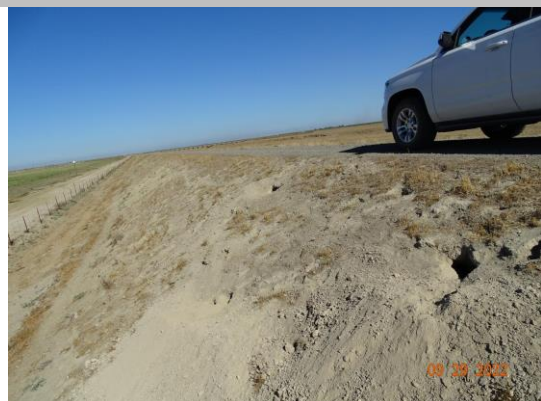
Photo 1 of 1 : SP_2024_NA0010_124_149_20240212_00067.jpg

LM Start	21.24	Rating **	M	Issue No.	149
LM End	21.24	Issue Type +	Ma	Location *	LS
Category	Earthen Levee			GPS Latitude/Longitude	
				Start	End
Item	Animal Control			37.108126°	37.108126°
				-120.558461°	-120.558461°
DWR ID	DWR_NA0010_06_f_2022_149				
Comment Code					
A1 : Exterminate rodents and backfill and compact or grout burrows.					
Inspector Comment

View of multiple rodent holes on the landside slope. (Fall 2022)

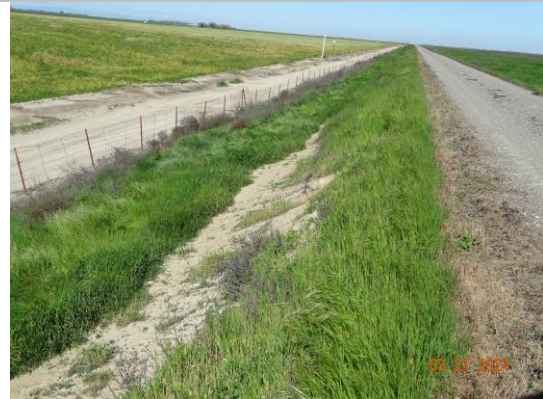
Photo 1 of 1 : SP_2024_NA0010_124_107_20240326_00156.jpg

LM Start	21.71	Rating **	M	Issue No.	107
LM End	21.78	Issue Type +	Ma	Location *	LS
Category	Earthen Levee			GPS Latitude/Longitude	
				Start	End
Item	Erosion / Livestock			37.102844°	37.102002°
				-120.553160°	-120.552314°
DWR ID	DWR_NA0010_06_f_2018_107				
Comment Code					
E4 : Repair the levee slope damaged by livestock and prevent large animal access.					
Inspector Comment					
Erosion into levee prism due to livestock activities.

View of erosion in landside levee prism. (Spring 2024)

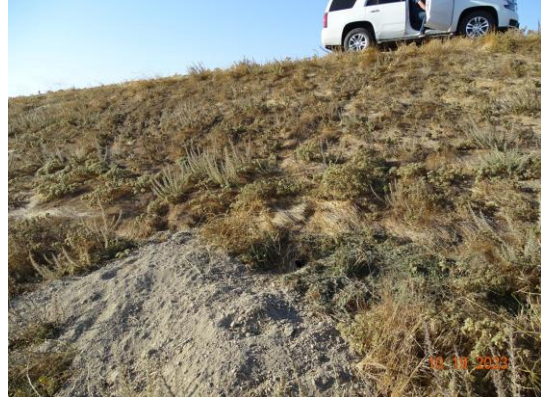
Photo 1 of 1 : SP_2024_NA0010_124_123_20240212_00045.jpg

LM Start	22.00	Rating **	M	Issue No.	123
LM End	22.00	Issue Type +	Ma	Location *	WS
Category	Earthen Levee			GPS Latitude/Longitude	
				Start	End
Item	Animal Control			37.099556°	37.099556°
				-120.549876°	-120.549876°
DWR ID	DWR_NA0010_06_f_2023_123				
Comment Code					
A1 : Exterminate rodents and backfill and compact or grout burrows.					
Inspector Comment

View of large animal burrow in the landside slope. (Fall 2023)

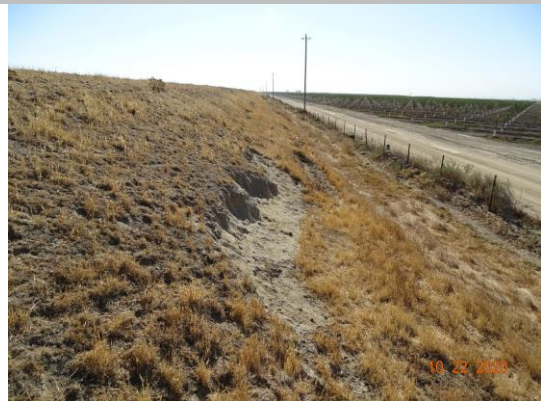
Photo 1 of 1 : SP_2024_NA0010_124_86_20240212_00022.jpg

LM Start	22.09	Rating **	M	Issue No.	86
LM End	22.46	Issue Type +	Ma	Location *	LS
Category	Earthen Levee			GPS Latitude/Longitude	
				Start	End
Item	Erosion / Livestock			37.098524°	37.094479°
				-120.548781°	-120.544435°
DWR ID	DWR_NA0010_06_f_2017_86				
Comment Code					
E4 : Repair the levee slope damaged by livestock and prevent large animal access.					
Inspector Comment					
Erosion greater than 3 inches on landside slope caused by livestock.

Looking upstream along the landside slope. (Fall 2020)

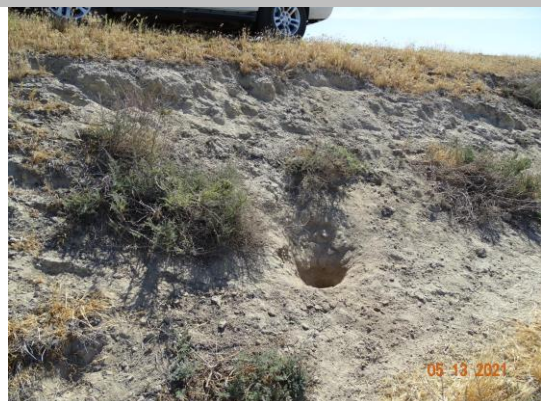
Photo 1 of 1 : SP_2024_NA0010_124_70_20240212_00014.jpg

LM Start	22.15	Rating **	U	Issue No.	70
LM End	22.15	Issue Type +	Ma	Location *	LS
Category	Earthen Levee			GPS Latitude/Longitude	
				Start	End
Item	Animal Control			37.097885°	37.097885°
				-120.548108°	-120.548108°
DWR ID	DWR_NA0010_06_s_2021_70				
Comment Code					
A3 : No rodents visible, but rodent burrows visible; need to backfill and compact or grout burrows.					
Inspector Comment

View of large rodent burrows in the landside slope. (Spring 2021)

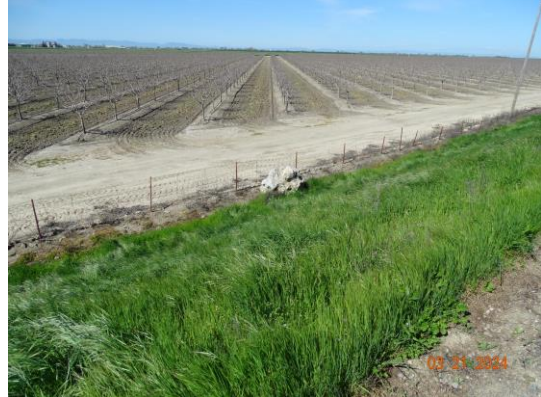
Photo 1 of 1 : SP_2024_NA0010_124_117_20240326_00157.jpg

LM Start	22.87	Rating **	M	Issue No.	117
LM End	22.87	Issue Type +	Ma	Location *	LS
Category	Earthen Levee			GPS Latitude/Longitude	
				Start	End
Item	Encroachments			37.089954°	37.089954°
				-120.539535°	-120.539535°
DWR ID	DWR_NA0010_06_f_2019_117				
Comment Code					
DE : Debris					
Inspector Comment					
Large block of concrete left on the landside toe.

Large concrete block left on the landside toe. (Spring 2024)

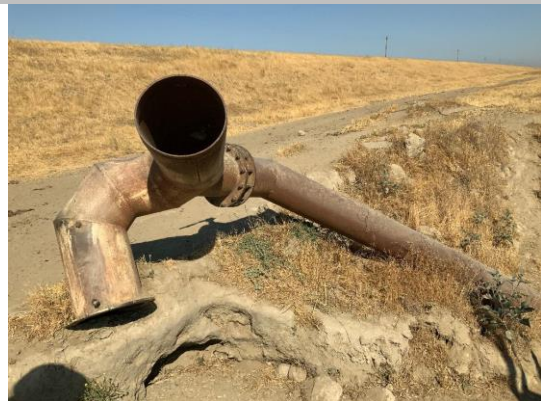
Photo 1 of 1 : UCIP_SP_2024_71142_101603.jpg

Comment Code					
Inspector Comment					
DS_ID:19812 FS_ID:71142 EP_NO: 12657 Repair Type: Non-Urgent EVAL Issue: 10, Unauthorized Modification or Non-Compliant Permit Crossing Status: Found UCIP Comments: 07/12/2021 The record has been upgraded from No Action Needed to Non-Urgent. One of the attached pipes on WS appears to have been removed and is not attached. Unable to access LS riser due to barbed wire. The UCIP inspection was completed with GEI staff, P. Espinoza. (H. Dunn – GEI) FIELD_STRUCT_DESC: 16-inch coated steel irrigation discharge pipe through the levee, 4.0 feet below the crown. Cutoff wall around the pipe at the center of the levee. Portable pump on the waterside (WS). Concrete standpipe on the landside (LS) slope with a timber walkway access ramp. Siphon breaker on the LS shoulder. Intake trench from the channel to the WS toe. (Diversion pump and discharge pipe authorized under Permit No. 12657, 1979 - Laurie H. Hall, Mary H. Hicks, and William E. Hammonds). [Additional Reference(s): DWR Levee Log, 2002, (HLM 22.82)]. FS Date: 7/12/2021

WS view: Portion of pipe not attached and discarded.

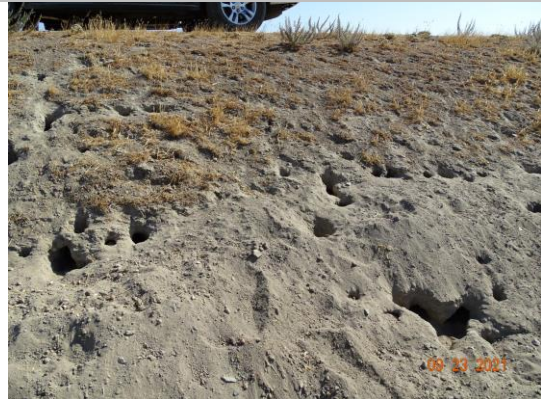
Photo 1 of 1 : SP_2024_NA0010_124_110_20240212_00036.jpg

LM Start	23.11	Rating **	M	Issue No.	110
LM End	23.11	Issue Type +	Ma	Location *	LS
Category	Earthen Levee			GPS Latitude/Longitude	
				Start	End
Item	Animal Control			37.087312°	37.087312°
				-120.536662°	-120.536662°
DWR ID	DWR_NA0010_06_f_2021_110				
Comment Code					
A3 : No rodents visible, but rodent burrows visible; need to backfill and compact or grout burrows.					
Inspector Comment

View of rodent burrows on the landside slope. (Fall 2021)

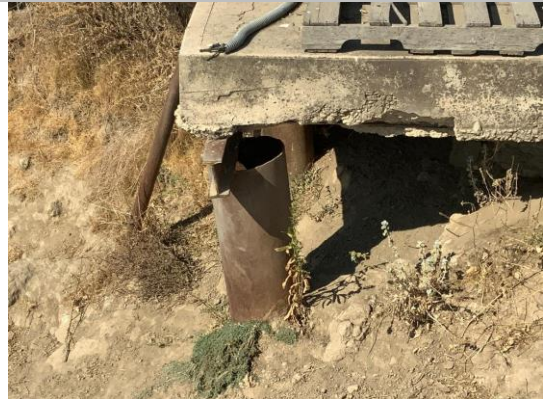
Photo 2 of 2 : UCIP_SP_2024_71143_101617.jpg

LM Start	24.02	Rating **	M	Issue No.	1248 (cont)
LM End	24.02	Issue Type +	En	Location *	
Category	Supplemental		GPS Latitude/Longitude		
			Start	End	
Item	DWR UCIP Field Study		37.077406°	37.077406°	
			-120.525938°	-120.525938°	
DWR ID	19879

WS view: Erosion under concrete pump pad and instability at toe.

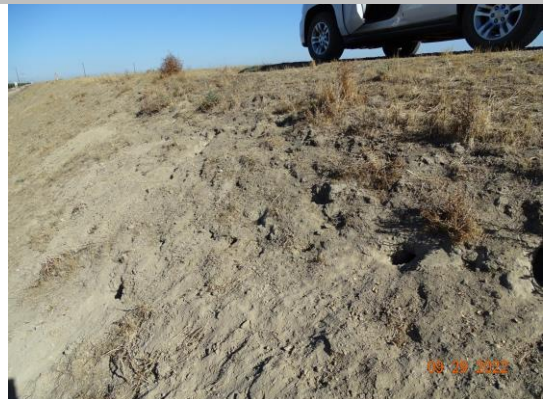
Photo 1 of 1 : SP_2024_NA0010_124_145_20240212_00063.jpg

LM Start	24.06	Rating **	M	Issue No.	145
LM End	24.06	Issue Type +	Ma	Location *	LS
Category	Earthen Levee			GPS Latitude/Longitude	
				Start	End
Item	Animal Control			37.076933°	37.076933°
				-120.525444°	-120.525444°
DWR ID	DWR_NA0010_06_f_2022_145				
Comment Code					
A3 : No rodents visible, but rodent burrows visible; need to backfill and compact or grout burrows.					
Inspector Comment

Several rodent holes observed at this location. (Fall 2022)

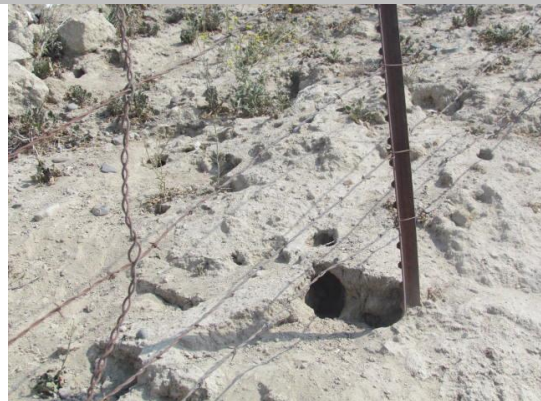
Photo 1 of 1 : SP_2024_NA0010_124_1208_20240212_00074.jpg

LM Start	26.13	Rating **	A/W	Issue No.	1208
LM End	26.13	Issue Type +	Ma	Location *	LS
Category	Earthen Levee			GPS Latitude/Longitude	
				Start	End
Item	Animal Control			37.054222°	37.054222°
				-120.500862°	-120.500862°
DWR ID	DWR_NA0010_06_s_2015_1208				
Comment Code					
A3 : No rodents visible, but rodent burrows visible; need to backfill and compact or grout burrows.					
Inspector Comment					
Noted several rodent holes next to and within rock revetment on landside slope.

Rodent holes on landward slope.

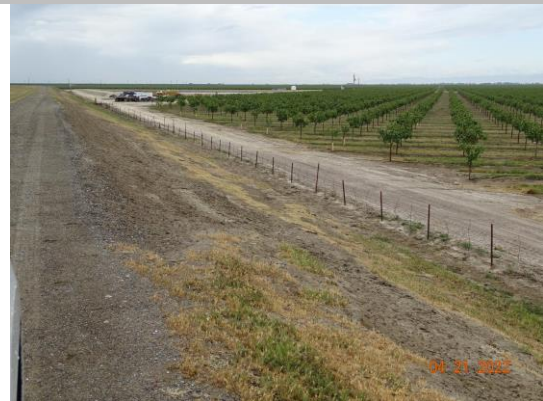
Photo 1 of 1 : SP_2024_NA0010_124_3_20240212_00005.jpg

LM Start	27.43	Rating **	U	Issue No.	3
LM End	27.99	Issue Type +	Ma	Location *	LS
Category	Earthen Levee			GPS Latitude/Longitude	
				Start	End
Item	Erosion / Livestock			37.036955°	37.032762°
				-120.484395°	-120.481078°
DWR ID	DWR_NA0010_06_s_2012_3				
Comment Code					
E4 : Repair the levee slope damaged by livestock and prevent large animal access.					
Inspector Comment					
Landside erosion and slope instability caused by livestock. Erosion greater than 3" in depth on landside slope. Levee crown has narrowed within this reach.

Looking south along landside slope. (Spring 2022)

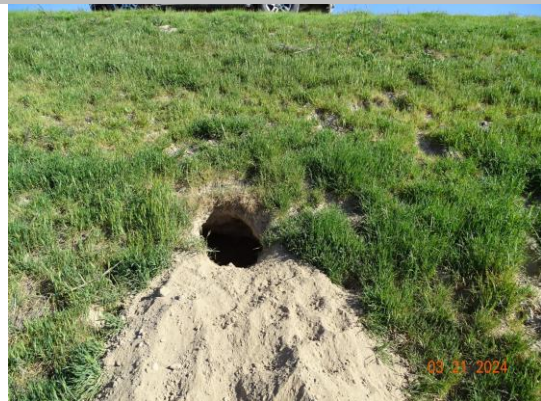
Photo 1 of 1 : SP_2024_NA0010_124_52_20240326_00158.jpg

LM Start	28.32	Rating **	M	Issue No.	52
LM End	28.32	Issue Type +	Ma	Location *	LS
Category	Earthen Levee			GPS Latitude/Longitude	
				Start	End
Item	Animal Control			37.030171°	37.030171°
				-120.476141°	-120.476141°
DWR ID	DWR_NA0010_06_s_ 2024_52				
Comment Code					
A3 : No rodents visible, but rodent burrows visible; need to backfill and compact or grout burrows.					
Inspector Comment

Large rodent hole observed near the landside hinge point. (Spring 2024)

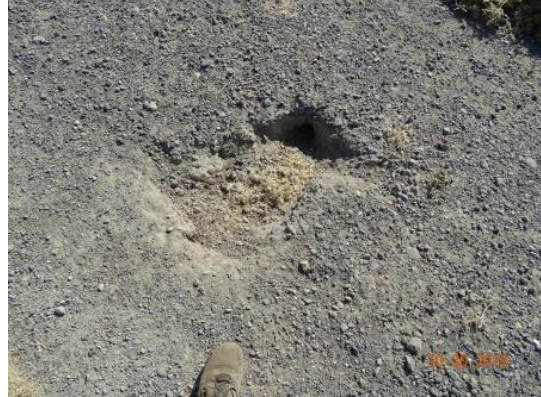
Photo 1 of 1 : SP_2024_NA0010_124_19_20240212_00008.jpg

LM Start	28.47	Rating **	M	Issue No.	19
LM End	28.53	Issue Type +	Ma	Location *	LS
Category	Earthen Levee			GPS Latitude/Longitude	
				Start	End
Item	Animal Control			37.029937°	37.029977°
				-120.473384°	-120.472266°
DWR ID	DWR_NA0010_06_s_ 2015_19				
Comment Code					
A3 : No rodents visible, but rodent burrows visible; need to backfill and compact or grout burrows.					
Inspector Comment					
Rodent burrows on the landside slope and crown.

View of rodent burrow in the levee crown. (Fall 2019)

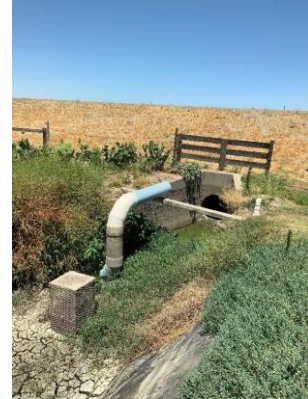
Photo 1 of 3 : UCIP_SP_2024_71146_103939.jpg

Comment Code						
Inspector Comment						
DS_ID:19881 FS_ID:71146 EP_NO: N/A Repair Type: Non-Urgent EVAL Issue: 4b, Safety Issue Crossing Status: Found UCIP Comments: 06/24/2021 The record remains Non-Urgent. WS inlet had sediment build up in pipe; recommend removal. Build up of debris in CMP riser on WS slope; recommend removal. WS CMP riser is missing lid, causing safety hazard. LS pipe outlet had elevated water levels around the headwall and pipe, limited ability to inspect closely. Unidentified pipe has been installed off 15 feet from the toe of LS headwall; does not affect crossing. No permit was found authorizing this encroachment. CVFPB will need to review crossing to determine owner. The UCIP inspection was completed with GEI staff, H.Dunn. (P.Espinoza – GEI) 04/10/2014 Dense vegetation limits the inspector's visibility to identify signs of pipe failure (leaks) along the slopes. Recommend removing vegetation along pipe alignment to conduct proper inspection of structure. (O. Magana - DWR UCIP) FIELD_STRUCT_DESC: 36-inch corrugated metal gravity irrigation pipe (CMP) through the levee, 12.4 feet below the crown. Slide gate in a 48-inch CMP riser unit on the waterside (WS) slope. Concrete U-shaped headwall on each end. Cobble pad on the landside (LS). [Additional Reference(s): DWR Levee Log, 2002, (HLM 29.34). USACE San Joaquin O&M Manual, Unit No. 601, Part No. 1, 1967, Amended in 1978, Revised 20 June 1985, (HLM 29.34). DWR As-Built Specification No. 64-01, Sheet No. 10, 6 November 1963, (HLM 29.34)]. FS Date: 6/24/2021 4:24:00 PM

LS view: Concrete headwall and slope from toe. Unidentified pipes near entrance of outlet pipe.

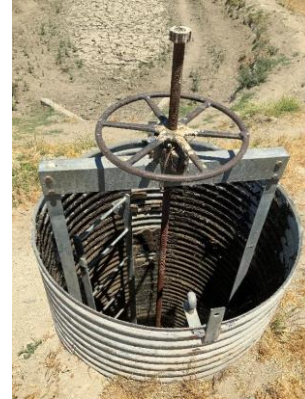
Photo 2 of 3 : UCIP_SP_2024_71146_103935.jpg

WS view: Close up of CMP riser with slide gate located on slope.

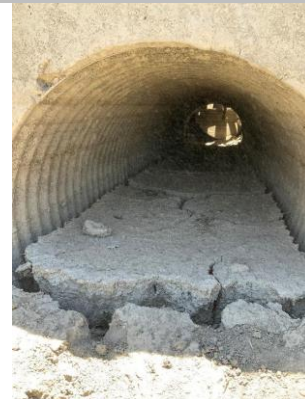
Photo 3 of 3 : UCIP_SP_2024_71146_103938.jpg

WS view: Inside of inlet pipe at toe.

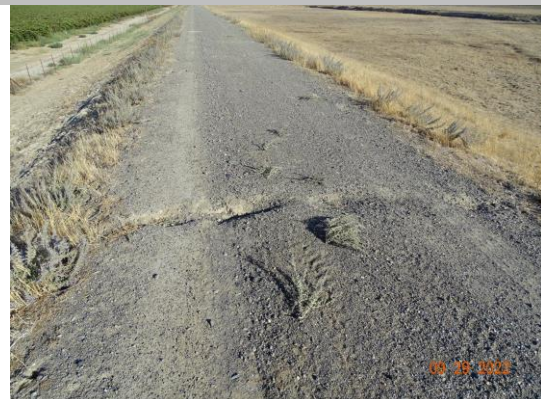
Photo 1 of 1 : SP_2024_NA0010_124_139_20240212_00057.jpg

LM Start	30.79	Rating **	M	Issue No.	139
LM End	30.79	Issue Type +	Ma	Location *	CR
Category	Earthen Levee			GPS Latitude/Longitude	
				Start	End
Item	Animal Control			37.021804°	37.021804°
				-120.437703°	-120.437703°
DWR ID	DWR_NA0010_06_f_2022_139				
Comment Code					
A3 : No rodents visible, but rodent burrows visible; need to backfill and compact or grout burrows.					
Inspector Comment					
Collapsed rodent burrow has created a few depressions in the crown at this location.

Depression in the levee crown. (Fall 2022)

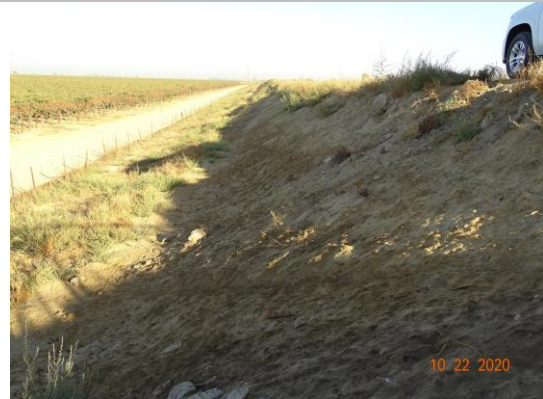
Photo 1 of 1 : SP_2024_NA0010_124_1207_20240212_00073.jpg

LM Start	30.81	Rating **	M	Issue No.	1207
LM End	31.06	Issue Type +	Ma	Location *	LS
Category	Earthen Levee			GPS Latitude/Longitude	
				Start	End
Item	Erosion / Livestock			37.021615°	37.018428°
				-120.437587°	-120.435378°
DWR ID	DWR_NA0010_06_s_2015_1207				
Comment Code					
E4 : Repair the levee slope damaged by livestock and prevent large animal access.					
Inspector Comment					
Landside erosion greater than 1" in depth and greater than 3" in length. Erosion is caused by livestock traffic.

Looking upstream at livestock damage to the landside slope. (Fall 2020)

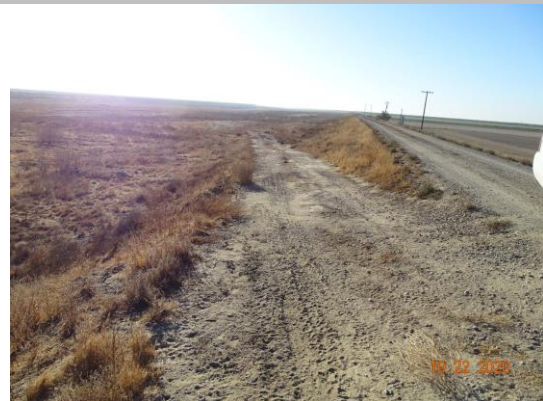
Photo 1 of 1 : SP_2024_NA0010_124_80_20240212_00019.jpg

LM Start	31.10	Rating **	M	Issue No.	80
LM End	31.10	Issue Type +	En	Location *	WS
Category	Earthen Levee			GPS Latitude/Longitude	
				Start	End
Item	Encroachments			37.017907°	37.017907°
				-120.434970°	-120.434970°
DWR ID	DWR_NA0010_06_s_2017_80				
Comment Code					
RA : Ramp					
Inspector Comment					
Farmer installed ramp on waterside slope.

Looking upstream at ramp on the waterside slope. (Fall 2020)

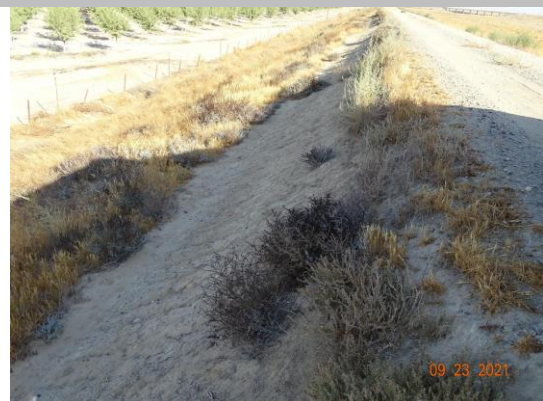
Photo 1 of 1 : SP_2024_NA0010_124_108_20240212_00035.jpg

LM Start	31.50	Rating **	M	Issue No.	108
LM End	31.70	Issue Type +	Ma	Location *	LS
Category	Earthen Levee			GPS Latitude/Longitude	
				Start	End
Item	Erosion / Livestock			37.012830°	37.010335°
				-120.431523°	-120.429817°
DWR ID	DWR_NA0010_06_f_2021_108				
Comment Code					
E4 : Repair the levee slope damaged by livestock and prevent large animal access.					
Inspector Comment

View of the landside slope looking downstream. (Fall 2021)

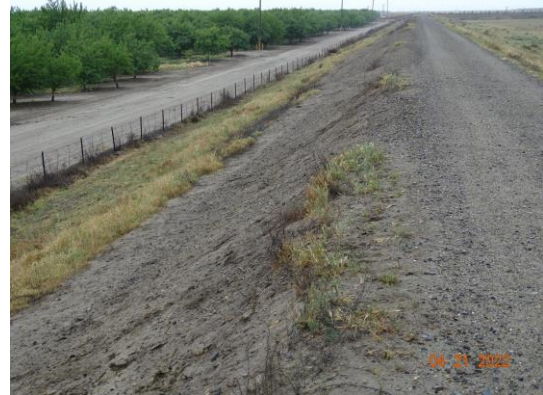
Photo 1 of 1 : SP_2024_NA0010_124_129_20240212_00049.jpg

LM Start	32.37	Rating **	U	Issue No.	129
LM End	32.88	Issue Type +	Ma	Location *	LS
Category	Earthen Levee			GPS Latitude/Longitude	
				Start	End
Item	Erosion / Livestock			37.003251 °	36.997745 °
				-120.421556 °	-120.415197 °
DWR ID	DWR_NA0010_06_s_2022_129				
Comment Code					
E4 : Repair the levee slope damaged by livestock and prevent large animal access.					
Inspector Comment					
Slope damage from livestock. Damage is beginning to erode into levee crown.

Erosion from livestock activity along the landside slope. (Spring 2022)
