Flood Control Project Maintenance
Levee Inspections
LMA District Cover Sheet

Lower San Joaquin Levee District

**Flood Control Project Maintenance
Levee Inspections
Unit Cover Sheet**

Levee Inspection Report By Mile - Spring 2024

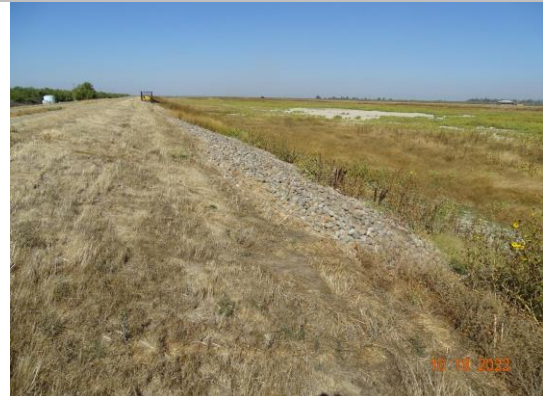
Photo 1 of 1 : SP_2024_NA0010_124_87_20240212_00023.jpg

LM Start	32.92	Rating **	A/W	Issue No.	87
LM End	33.14	Issue Type +	Ma	Location *	WS
Category	Earthen Levee			GPS Latitude/Longitude	
				Start	End
Item	Riprap Revetments			36.997386 °	36.994944 °
				-120.414850 °	-120.412131 °
DWR ID	DWR_NA0010_06_f_2023_87				
Comment Code					
RR : Riprap Revetments					
Inspector Comment

View of revetment placed on the waterside slope. (Fall 2023)

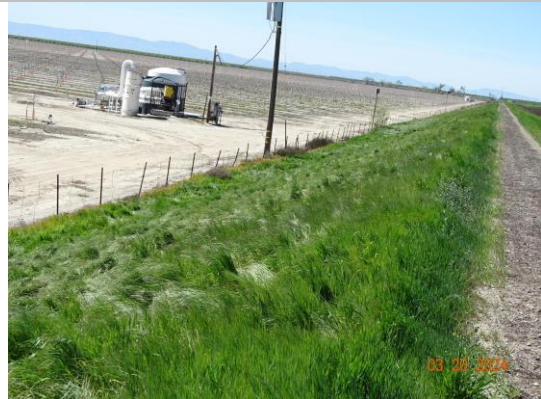
Photo 1 of 1 : SP_2024_NA0010_124_50_20240326_00159.jpg

LM Start	35.68	Rating **	M	Issue No.	50
LM End	36.35	Issue Type +	Ma	Location *	LS
Category	Earthen Levee			GPS Latitude/Longitude	
				Start	End
Item	Vegetation			36.974363°	36.974407°
				-120.377373°	-120.365412°
DWR ID	DWR_NA0010_06_s_ 2024_50				
Comment Code					
V1 : Control annual grass and weeds on the levee slopes and easements.					
Inspector Comment

View of vegetation growing on the landside slope. (Spring 2024)

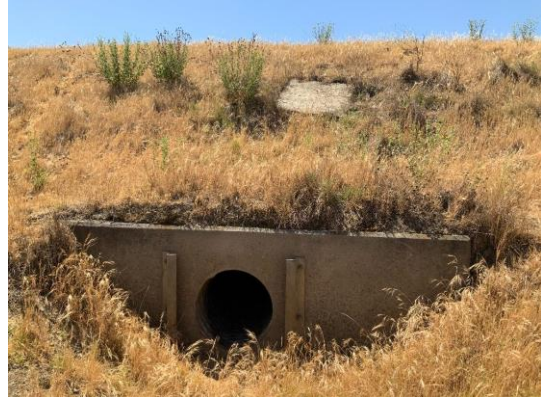
Photo 1 of 3 : UCIP_SP_2024_71165_99441.jpg

Comment Code					
Inspector Comment					
DS_ID:19892 FS_ID:71165 EP_NO: N/A Repair Type: Non-Urgent EVAL Issue: Crossing Status: Found UCIP Comments: 06/2/2021 Record remains Non-Urgent. DWR DMP internal inspection has not found pipe integrity issues. LOF of crossing is less or equal to 4.0. Recommend next video inspection in 5 years. No permit was found authorizing this encroachment. CVFPB will need to review crossing to determine owner. The UCIP inspection was completed with GEI staff, P. Espinoza. (H. Dunn – GEI) 07/20/2016 Inlet blocked off by wooden board. Dense vegetation limits the inspector's visibility to identify signs of pipe failure (leaks) along WS and LS. Crossing downgraded from Urgent to Non-Urgent. (O. Magana - DWR UCIP)04/15/2014 Flapgate partially blocked by soil buildup at WS toe. (W. Wylie - DWR UCIP) FIELD_STRUCT_DESC: 24-inch corrugated metal gravity drainage pipe (CMP) through the levee, 10.8 feet below the crown. Flap gate on the waterside (WS) end. Concrete headwall on the landside (LS) end. Concrete U-shaped headwall on the WS end. [Additional Reference(s): DWR Levee Log, 2002, (HLM 0.08). USACE San Joaquin O&M Manual, Unit No. 601, Part No. 1, 1967, Amended in 1978, Revised 20 June 1985, (HLM 0.07). DWR As-Built Specification No. 63-25, Sheet No. 11, 9 May 1963, (HLM 0.07)]. FS Date: 6/2/2021

LS view: Slope and headwall at toe.

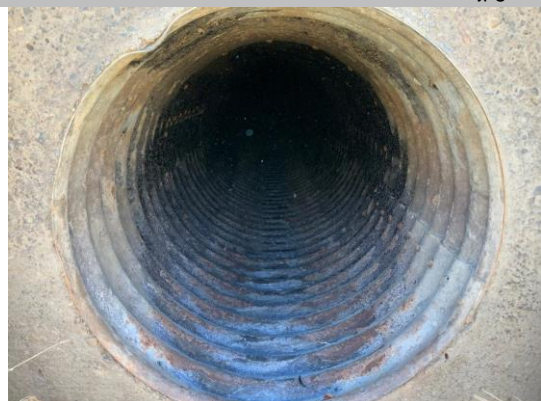
Photo 2 of 3 : UCIP_SP_2024_71165_99442.jpg

LS view: Close up of pipe inlet at toe.

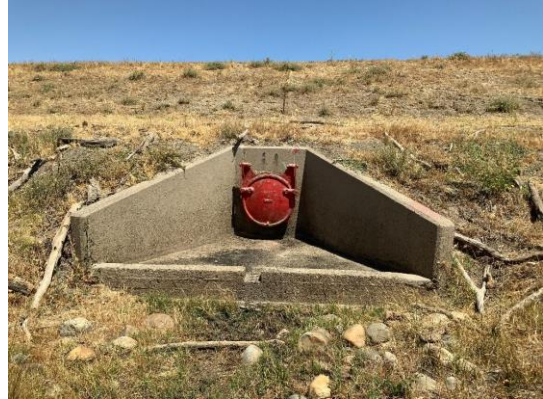
Photo 3 of 3 : UCIP_SP_2024_71165_99438.jpg

WS view: Slope, headwall, and flapgate at toe.

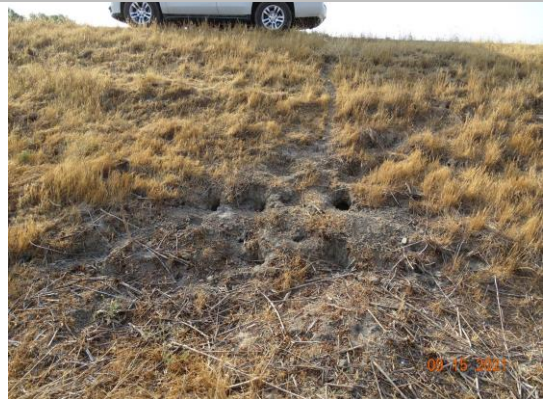
Photo 1 of 1 : SP_2024_NA0010_125_17_20240212_00005.jpg

LM Start	0.10	Rating **	M	Issue No.	17
LM End	0.10	Issue Type +	Ma	Location *	LS
Category	Earthen Levee			GPS Latitude/Longitude	
				Start	End
Item	Animal Control			37.256017°	37.256017°
				-120.770636°	-120.770636°
DWR ID	DWR_NA0010_07_f_2021_17				
Comment Code					
A3 : No rodents visible, but rodent burrows visible; need to backfill and compact or grout burrows.					
Inspector Comment

View of rodent holes in the landside slope. (Fall 2021)

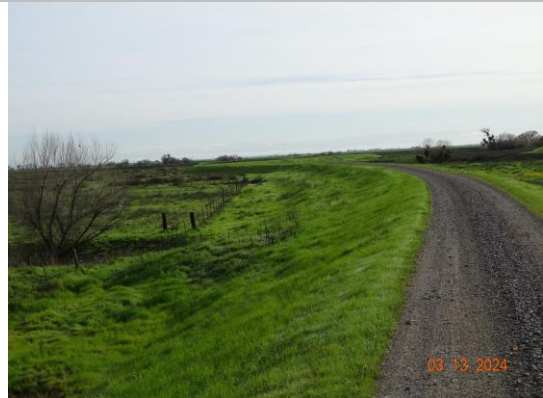
Photo 1 of 1 : SP_2024_NA0010_125_24_20240326_00046.jpg

LM Start	0.12	Rating **	A	Issue No.	24
LM End	0.12	Issue Type +	Ma	Location *	LS
Category	Earthen Levee			GPS Latitude/Longitude	
				Start	End
Item	Vegetation			37.256030°	37.256030°
				-120.770350°	-120.770350°
DWR ID	DWR_NA0010_07_s_2024_24				
Comment Code					
V1 : Control annual grass and weeds on the levee slopes and easements.					
Inspector Comment

View of the landside slope looking upstream. (Spring 2024)

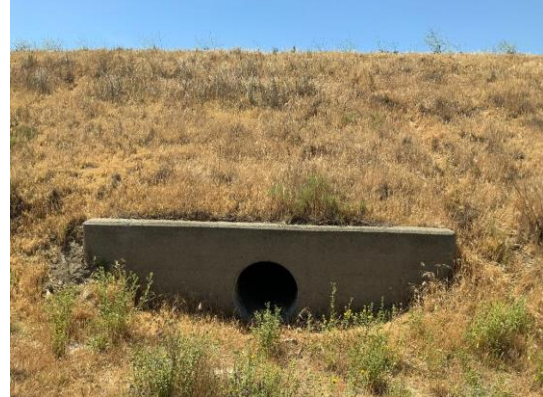
Photo 1 of 3 : UCIP_SP_2024_71166_99448.jpg

Comment Code						
Inspector Comment						
DS_ID:19893 FS_ID:71166 EP_NO: N/A Repair Type: Non-Urgent EVAL Issue: Crossing Status: Found UCIP Comments: 06/2/2021 The record has been upgraded from No Action Needed to Non-Urgent. DWR DMP internal inspection has not found pipe integrity issues. LOF of crossing is less or equal to 4.0. Recommend next video inspection in 5 years. No permit was found authorizing this encroachment. CVFPB will need to review crossing to determine owner. The UCIP inspection was completed with GEI staff, P. Espinoza. (H. Dunn – GEI) FIELD_STRUCT_DESC: 24-inch corrugated metal gravity drainage pipe (CMP) through the levee, 11.1 feet below the crown. Flap gate on the waterside (WS) end. Concrete headwall on the landside (LS) end. Concrete U-shaped headwall on the WS end. [Additional Reference(s): DWR Levee Log, 2002, (HLM 0.34). USACE San Joaquin O&M Manual, Unit No. 601, Part No. 1, 1967, Amended in 1978, Revised 20 June 1985, (HLM 0.33). DWR As-Built Specification No. 63-25, Sheet No. 11, 9 May 1963, (HLM 0.33)]. FS Date: 6/2/2021

LS view: Slope and headwall at toe.

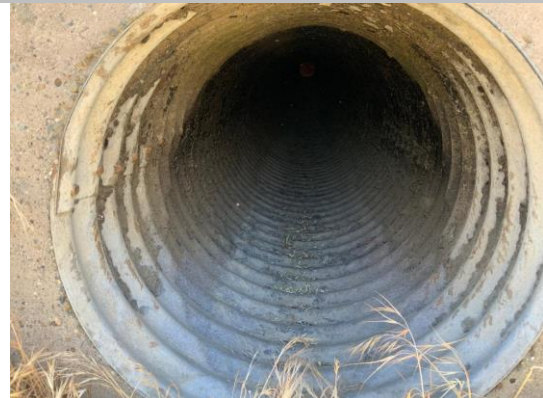
Photo 2 of 3 : UCIP_SP_2024_71166_99443.jpg

LS view: Close up of pipe inlet at toe.

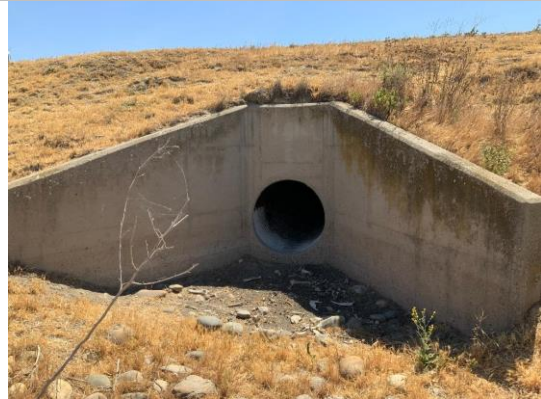
Photo 1 of 3 : UCIP_SP_2024_71167_99450.jpg

Comment Code						
Inspector Comment						
DS_ID:19894 FS_ID:71167 EP_NO: N/A Repair Type: Non-Urgent EVAL Issue: 4b, Safety Issue Crossing Status: Found UCIP Comments: 06/2/2021 Record remains Non-Urgent. No cover over the WS metal riser. There is debris and wood pallets within the riser that may prevent the ability for the slidegate to be opened or water to flow through, recommend cleaning out. DWR DMP internal inspection has not found pipe integrity issues. LOF of crossing is less or equal to 4.0. Recommend next video inspection in 5 years. No permit was found authorizing this encroachment. CVFPB will need to review crossing to determine owner. The UCIP inspection was completed with GEI staff, P. Espinoza. (H. Dunn – GEI) 04/15/2014 Slide gate not operable, but left in closed position. Need to reinstall covers over slide gate standpipe. (W. Wylie - DWR UCIP) FIELD_STRUCT_DESC: 36-inch corrugated metal gravity drainage pipe (CMP) through the levee, 9.7 feet below the crown. Slide gate in a 48-inch CMP riser unit on the landside (LS) slope. Concrete U-shaped headwall on the LS end. Inlet channel cobble revetted. Dilapidated wooden pier on the waterside (WS). WS slope and outlet ditch cobble revetted. [Additional Reference(s): DWR Levee Log, 2002, (HLM 0.49). USACE San Joaquin O&M Manual, Unit No. 601, Part No. 1, 1967, Amended in 1978, Revised 20 June 1985, (HLM 0.49). DWR As-Built Specification No. 63-25, Sheet No. 11, 9 May 1963, (HLM 0.49)]. FS Date: 6/2/2021

LS view: Slope and headwall at toe.

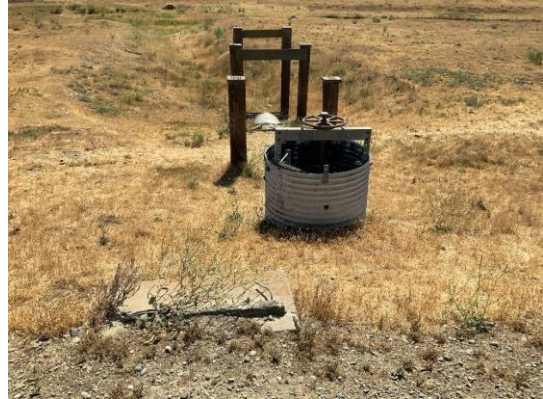
Photo 2 of 3 : UCIP_SP_2024_71167_99453.jpg

WS view: Slope with metal riser and slidegate from crown.

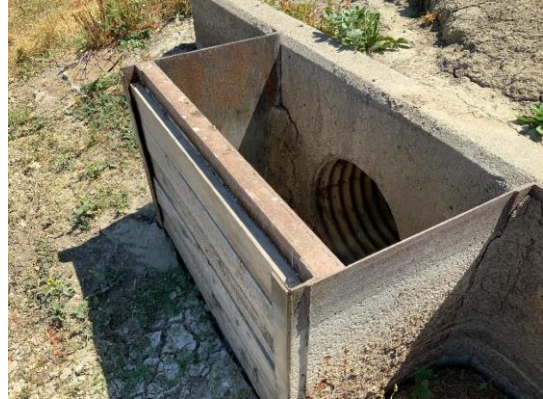
Photo 1 of 3 : UCIP_SP_2024_72517_99457.jpg

DS_ID:19895
FS_ID:72517
EP_NO: N/A
Repair Type: Urgent
EVAL Issue: 3a, Flood Risk
Crossing Status: Found
UCIP Comments: 05/04/2023 Enforcement Case No. 2023-15633 was issued to this crossing for unauthorized modifications that include: Unauthorized removal of flood control flapgate on the waterside of the levee, adding flashboards and metal brackets to landside and waterside concrete headwalls. (O.Yakimov - DWR UCIP)
06/2/2021 The record has been upgraded from No Action Needed to Urgent. There are plywood barriers on both WS and LS pipe ends, but no flapgate on either, and flapgate removed on WS. DWR DMP internal inspection has not found pipe integrity issues. LOF of crossing is less or equal to 4.0. Recommend next video inspection in 5 years. The UCIP inspection was completed with GEI staff, P. Espinoza. (H. Dunn – GEI)
FIELD_STRUCT_DESC: 24-inch corrugated metal gravity drainage pipe (CMP) through the levee, 9.0 feet below the crown. Flap gate on the waterside (WS) end. Concrete headwall with a wooden weir at the inlet on the landside (LS) toe. Concrete U-shaped headwall on the WS toe. [Additional Reference(s): DWR Levee Log, 2002, (HLM 0.53). USACE San Joaquin O&M Manual, Unit No. 601, Part No. 1, 1967, Amended in 1978, Revised 20 June 1985, (HLM 0.53). DWR As-Built Specification No. 63-25, Sheet No. 11, 9 May 1963, (HLM 0.53)].

LS view: Close up of plywood barrier at toe.

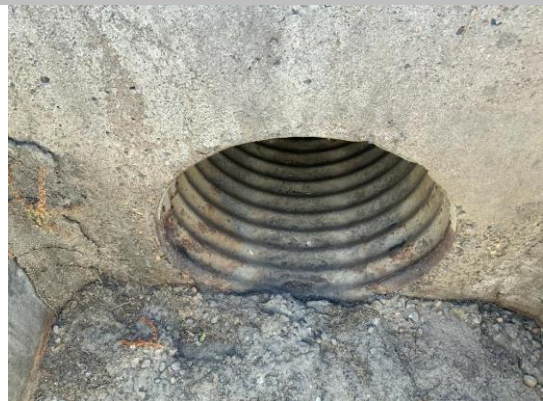
Photo 2 of 3 : UCIP_SP_2024_72517_99458.jpg

LS view: Close up of pipe inlet at toe.

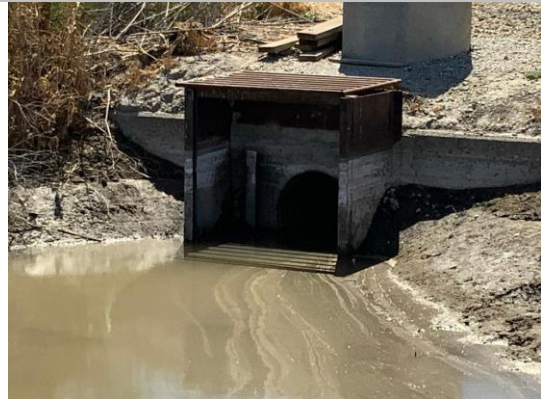
Photo 2 of 3 : UCIP_SP_2024_71169_99466.jpg

LS view: Close up of pipe inlet at toe.

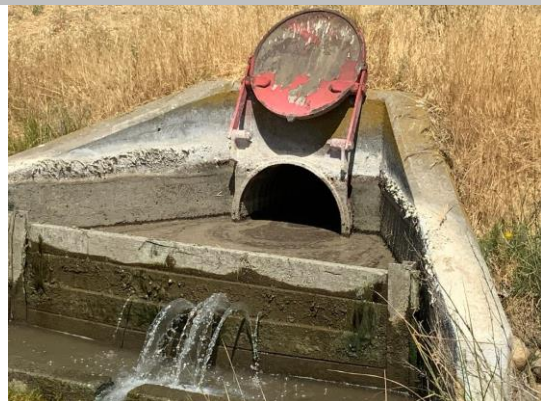
Photo 3 of 3 : UCIP_SP_2024_71169_99470.jpg

WS view: Close up of flapgate at toe.

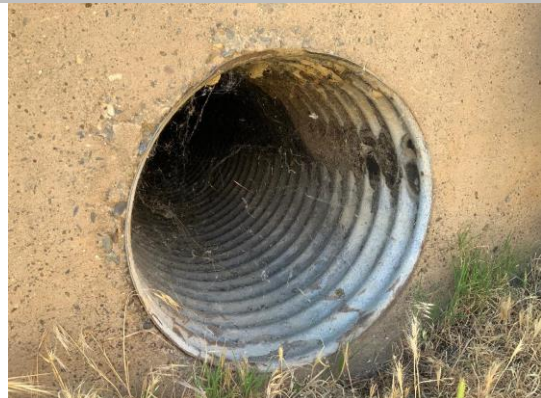
Photo 2 of 3 : UCIP_SP_2024_71170_99473.jpg

LS view: Close up of pipe inlet.

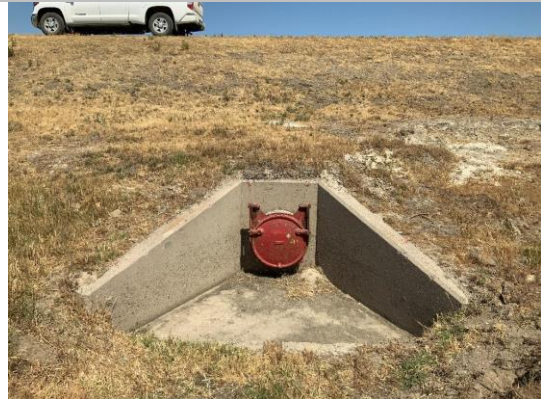
Photo 3 of 3 : UCIP_SP_2024_71170_99476.jpg

WS view: Slope, headwall, and flapgate at toe.

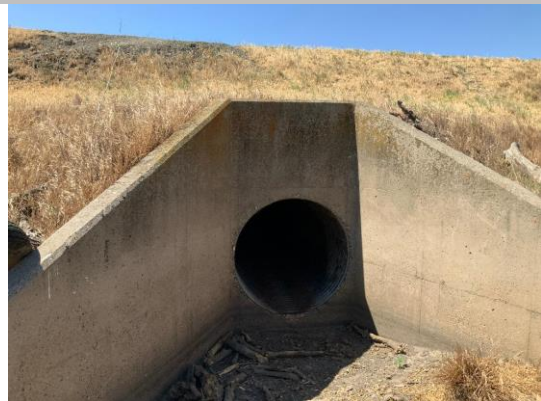
Photo 1 of 3 : UCIP_SP_2024_81167_99483.jpg

DS_ID:19898
 FS_ID:81167
 EP_NO: N/A
 Repair Type: No Action Needed
 EVAL Issue:
 Crossing Status: Found
 UCIP Comments: 09/25/2023 DMP internal video inspection has found none or minor pipe defects. Recommend next video inspection in 5 years. (J. Taylor - DWR UCIP)06/2/2021 The record has been upgraded from No Action Needed to Non-Urgent. No permit was found authorizing this encroachment. CVFPB will need to review crossing to determine owner. The UCIP inspection was completed with GEI staff, P. Espinoza. (H. Dunn – GEI)
 FIELD_STRUCT_DESC: 48-inch CIPP lined corrugated metal gravity drainage pipe (CMP) through the levee, 14.6 feet below the crown. Flap gate on the waterside (WS) end. Concrete U-shaped headwall on each end. [Additional Reference(s): DWR Levee Log, 2002, (HLM 1.17). USACE San Joaquin O&M Manual, Unit No. 601, Part No. 1, 1967, Amended in 1978, Revised 20 June 1985, (HLM 1.17). DWR As-Built Specification No. 63-25, Sheet No. 11, 9 May 1963, (HLM 1.17)].

LS view: Slope and headwall at toe.

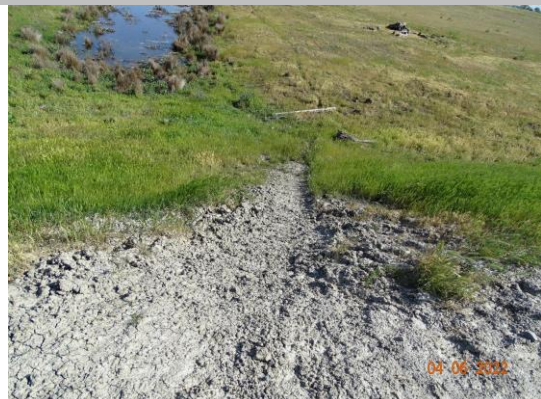
Photo 1 of 1 : SP_2024_NA0010_125_25_20240212_00011.jpg

LM Start	1.24	Rating **	A/W	Issue No.	25
LM End	1.24	Issue Type +	Ma	Location *	LS
Category	Earthen Levee			GPS Latitude/Longitude	
				Start	End
Item	Erosion / Livestock			37.264365°	37.264365°
				-120.755358°	-120.755358°
DWR ID	DWR_NA0010_07_s_2022_25				
Comment Code					
E4 : Repair the levee slope damaged by livestock and prevent large animal access.					
Inspector Comment

Looking down the landside slope at erosion from livestock traffic. (Spring 2022)

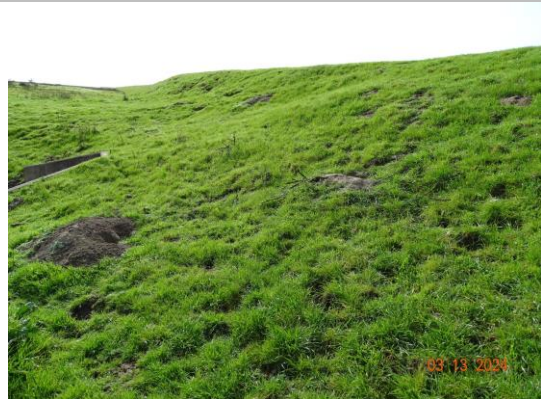
Photo 1 of 1 : SP_2024_NA0010_125_6_20240326_00047.jpg

LM Start	1.50	Rating **	M	Issue No.	6
LM End	1.51	Issue Type +	Ma	Location *	LS
Category	Earthen Levee			GPS Latitude/Longitude	
				Start	End
Item	Animal Control			37.263955°	37.263885°
				-120.750751°	-120.750527°
DWR ID	DWR_NA0010_07_s_2014_6				
Comment Code					
A1 : Exterminate rodents and backfill and compact or grout burrows.					
Inspector Comment

View of rodent holes on the landside slope. (Spring 2024)

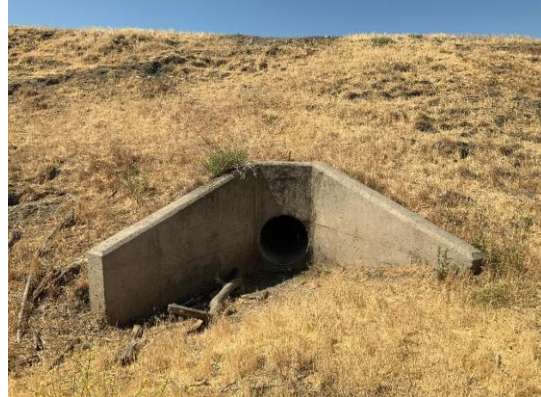
Photo 1 of 3 : UCIP_SP_2024_71172_99486.jpg

Comment Code					
Inspector Comment					
DS_ID:19902 FS_ID:71172 EP_NO: N/A Repair Type: Non-Urgent EVAL Issue: Crossing Status: Found UCIP Comments: 06/2/2021 The record has been upgraded from No Action Needed to Non-Urgent. DWR DMP internal inspection has not found pipe integrity issues. LOF of crossing is less or equal to 4.0. Recommend next video inspection in 5 years. No permit was found authorizing this encroachment. CVFPB will need to review crossing to determine owner. The UCIP inspection was completed with GEI staff, P. Espinoza. (H. Dunn – GEI) FIELD_STRUCT_DESC: 24-inch corrugated metal gravity drainage pipe (CMP) through the levee, 14.0 feet below the crown. Flap gate on the waterside (WS) end. Concrete U-shaped headwall on each end. [Additional Reference(s): DWR Levee Log, 2002, (HLM 1.51). USACE San Joaquin O&M Manual, Unit No. 601, Part No. 1, 1967, Amended in 1978, Revised 20 June 1985, (HLM 1.51). DWR As-Built Specification No. 63-25, Sheet No. 12, 9 May 1963, (HLM 1.51)]. FS Date: 6/2/2021

LS view: Slope and headwall at toe.

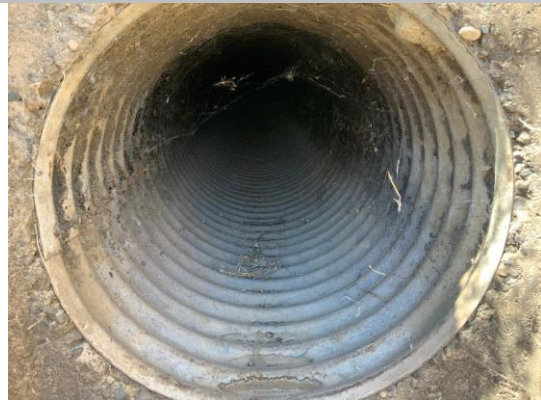
Photo 2 of 3 : UCIP_SP_2024_71172_99487.jpg

LS view: Close up of pipe inlet at toe.

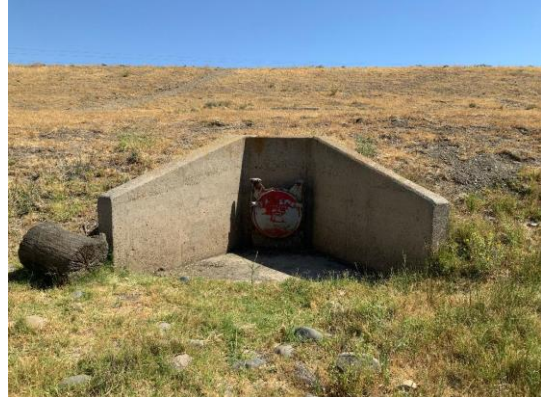
Photo 3 of 3 : UCIP_SP_2024_71172_99489.jpg

WS view: Slope, headwall, and flapgate at toe.

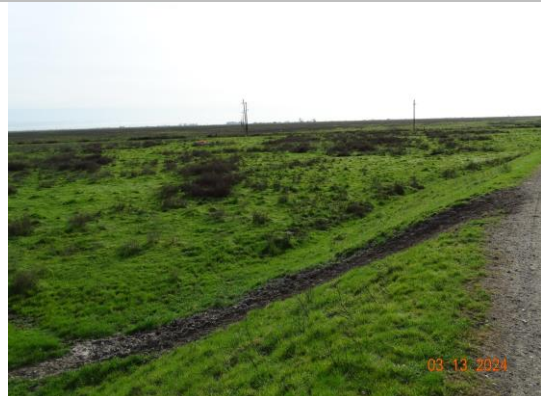
Photo 1 of 1 : SP_2024_NA0010_125_21_20240326_00048.jpg

LM Start	1.90	Rating **	M	Issue No.	21
LM End	1.90	Issue Type +	Ma	Location *	LS
Category	Earthen Levee			GPS Latitude/Longitude	
				Start	End
Item	Erosion / Livestock			37.261379°	37.261379°
				-120.744228°	-120.744228°
DWR ID	DWR_NA0010_07_f_2018_21				
Comment Code					
E4 : Repair the levee slope damaged by livestock and prevent large animal access.					
Inspector Comment

View of damage to the landside slope. (Spring 2024)

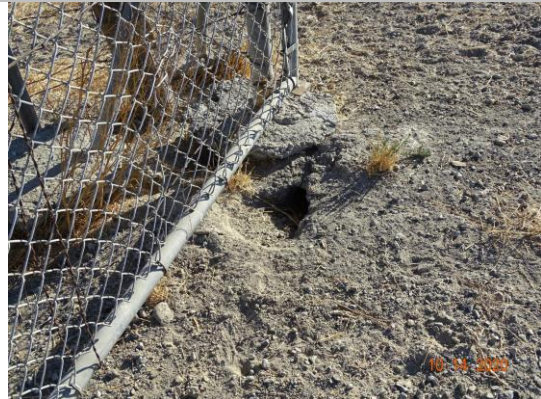
Photo 1 of 1 : SP_2024_NA0010_125_12_20240212_00002.jpg

LM Start	2.09	Rating **	A/W	Issue No.	12
LM End	2.09	Issue Type +	Ma	Location *	LS
Category	Earthen Levee			GPS Latitude/Longitude	
				Start	End
Item	Animal Control			37.259187°	37.259187°
				-120.742551°	-120.742551°
DWR ID	DWR_NA0010_07_f_2018_12				
Comment Code					
A3 : No rodents visible, but rodent burrows visible; need to backfill and compact or grout burrows.					
Inspector Comment

View of rodent hole at the fence post on the landside shoulder. (Fall 2020)

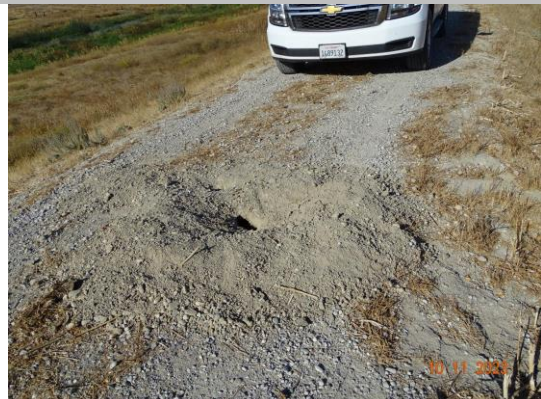
Photo 1 of 1 : SP_2024_NA0010_125_15_20240212_00003.jpg

LM Start	2.17	Rating **	A/W	Issue No.	15
LM End	2.17	Issue Type +	Ma	Location *	CR
Category	Earthen Levee			GPS Latitude/Longitude	
				Start	End
Item	Animal Control			37.258774°	37.258774°
				-120.741236°	-120.741236°
DWR ID	DWR_NA0010_07_f_2023_15				
Comment Code					
A3 : No rodents visible, but rodent burrows visible; need to backfill and compact or grout burrows.					
Inspector Comment					
Rodent holes with large amount of material displaced in the levee crown.

View of rodent hole with significant material displaced in the levee crown. (Fall 2023)

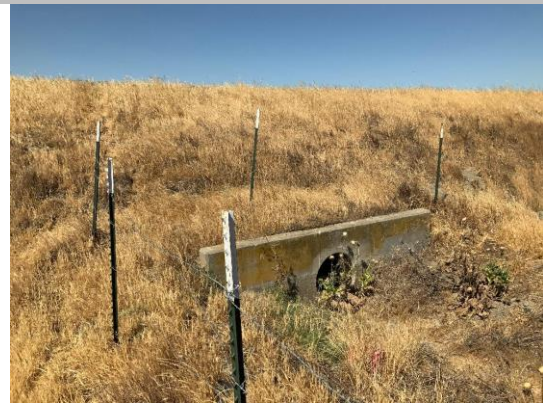
Photo 1 of 3 : UCIP_SP_2024_71173_99499.jpg

Comment Code					
Inspector Comment					
DS_ID:19899					
FS_ID:71173					
EP_NO: N/A					
Repair Type: Non-Urgent					
EVAL Issue:					
Crossing Status: Found					
UCIP Comments: 06/2/2021 The record has been upgraded from No Action Needed to Non-Urgent. LS pipe end surrounded by barbed wire, could not inspect closely. Metal pipe and plastic riser with flowmeter off the LS toe. DWR DMP internal inspection has not found pipe integrity issues. LOF of crossing is less or equal to 4.0. Recommend next video inspection in 5 years. No permit was found authorizing this encroachment. CVFPB will need to review crossing to determine owner. The UCIP inspection was completed with GEI staff, P. Espinoza. (H. Dunn – GEI)					
FIELD_STRUCT_DESC: 24-inch corrugated metal gravity drainage pipe (CMP) through the levee, 9.5 feet below the crown. Flap gate on the waterside (WS) end. Concrete headwall on the landside (LS) end. Concrete U-shaped headwall on the WS end. [Additional Reference(s): DWR Levee Log, 2002, (HLM 2.49). USACE San Joaquin O&M Manual, Unit No. 601, Part No. 1, 1967, Amended in 1978, Revised 20 June 1985, (HLM 2.48). DWR As-Built Specification No. 63-25, Sheet No. 12, 9 May 1963, (HLM 2.48)].

LS view: Slope and headwall at toe.

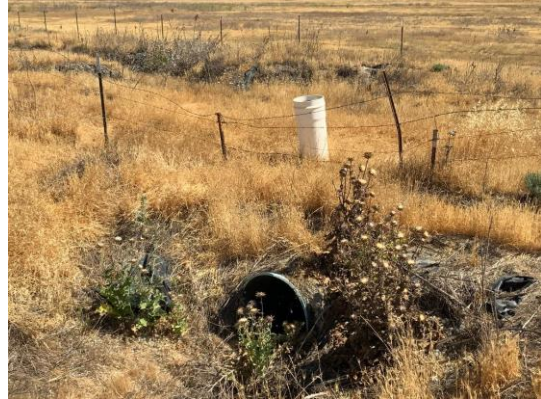
Photo 2 of 3 : UCIP_SP_2024_71173_99493.jpg

LS view: Pipe inlet and riser with flowmeter off toe.

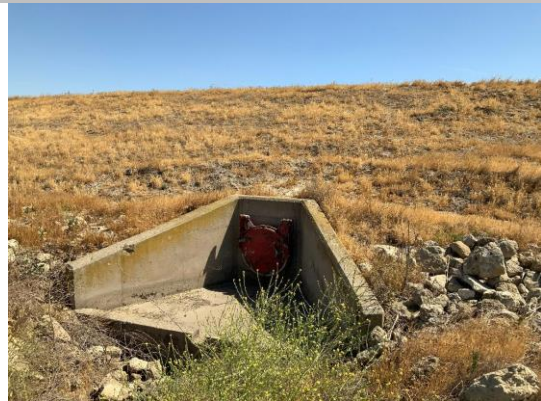
Photo 3 of 3 : UCIP_SP_2024_71173_99495.jpg

WS view: Slope, headwall, and flapgate at toe.

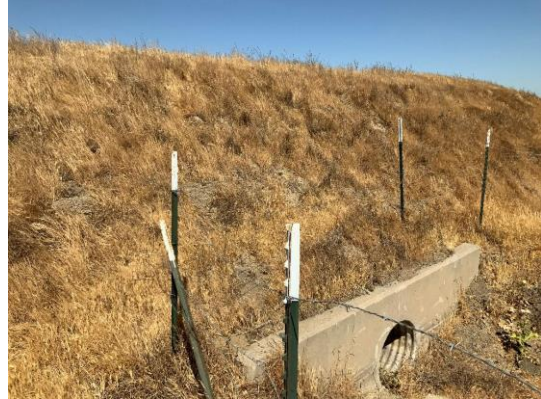
Photo 1 of 3 : UCIP_SP_2024_71174_99502.jpg

Comment Code					
Inspector Comment					
DS_ID:19900 FS_ID:71174 EP_NO: N/A Repair Type: Non-Urgent EVAL Issue: Crossing Status: Found UCIP Comments: 06/2/2021 The record has been upgraded from No Action Needed to Non-Urgent. LS pipe end surrounded by barbed wire, inspection was limited. No permit was found authorizing this encroachment. CVFPB will need to review crossing to determine owner. The UCIP inspection was completed with GEI staff, P. Espinoza. (H. Dunn – GEI) FIELD_STRUCT_DESC: 24-inch corrugated metal gravity drainage pipe (CMP) through the levee, 11.5 feet below the crown. Flap gate on the waterside (WS) end. Concrete headwall on the landside (LS) end. Concrete U-shaped headwall on the WS end. [Additional Reference(s): DWR Levee Log, 2002, (HLM 2.65). USACE San Joaquin O&M Manual, Unit No. 601, Part No. 1, 1967, Amended in 1978, Revised 20 June 1985, (HLM 2.64). DWR As-Built Specification No. 63-25, Sheet No. 12, 9 May 1963, (HLM 2.64)]. FS Date: 6/2/2021

LS view: Slope and headwall at toe.

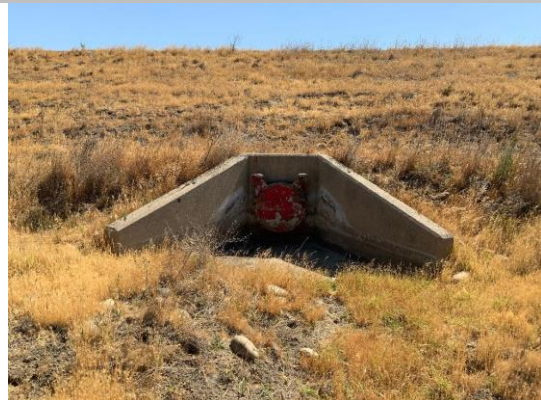
Photo 2 of 3 : UCIP_SP_2024_71174_99505.jpg

WS view: Slope, headwall, and flapgate at toe.

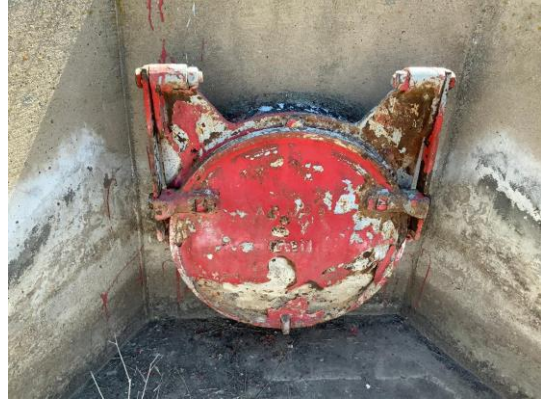
Photo 3 of 3 : UCIP_SP_2024_71174_99506.jpg

LM Start	2.63	Rating **	M	Issue No.	39 (cont)
LM End	2.63	Issue Type +	Ma	Location *	
Category	Supplemental			GPS Latitude/Longitude	
				Start	End
Item	DWR UCIP LMA Responsibility			37.254832°	37.254832°
				-120.734918°	-120.734918°
DWR ID	19900

WS view: Close up of flapgate at toe.

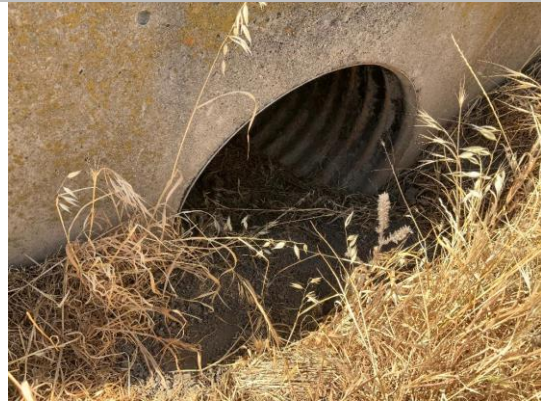
Photo 1 of 3 : UCIP_SP_2024_71175_99514.jpg

Comment Code						
Inspector Comment						
DS_ID:19901 FS_ID:71175 EP_NO: N/A Repair Type: No Action Needed EVAL Issue: Crossing Status: Found UCIP Comments: 09/18/2023 Record updated from Non-Urgent to No Action Needed. Pipe was CIPP lined. DMP internal video inspection has found none or minor pipe defects. Recommend next video inspection in 5 years. (O. Yakimov - DWR UCIP) 06/2/2021 Record remains Non-Urgent. DWR DMP internal inspection has found pipe integrity issues. LOF of crossing is equal to 4.1 and less than 5. Crossing will be monitored until funding becomes available for rehabilitation. Some sediment buildup in the inlet of the pipe on the LS, recommend cleaning out. No permit was found authorizing this encroachment. CVFPB will need to review crossing to determine owner. The UCIP inspection was completed with GEI staff, P. Espinoza. (H. Dunn – GEI) 04/15/2014 Some sediment buildup at landward toe and inside pipe--recommend clearing. (W. Wylie - DWR UCIP) FIELD_STRUCT_DESC: 24-inch CIPP-lined corrugated metal gravity drainage pipe (CMP) through the levee, 10.4 feet below the crown. Flap gate on the waterside (WS) end. Concrete headwall on the landside (LS) end. Concrete U-shaped headwall on the WS end. [Additional Reference(s): DWR Levee Log, 2002, (HLM 3.09). USACE San Joaquin O&M Manual, Unit No. 601, Part No. 1, 1967, Amended in 1978, Revised 20 June 1985, (HLM 3.09). DWR As-Built Specification No. 63-25, Sheet No. 13, 9 May 1963, (HLM 3.09)]. FS Date: 6/2/2021

LS view: Close up of pipe inlet at toe.

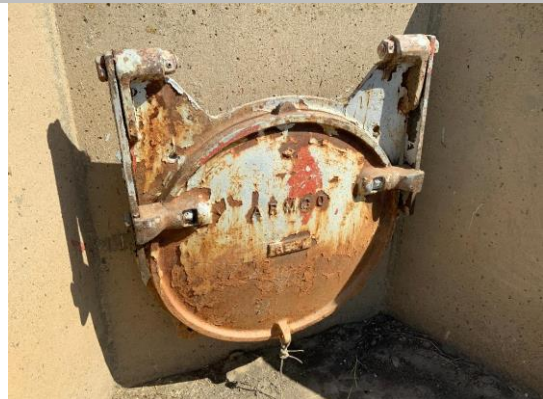
Photo 3 of 3 : UCIP_SP_2024_71175_99509.jpg

WS view: Close up of flapgate at toe.

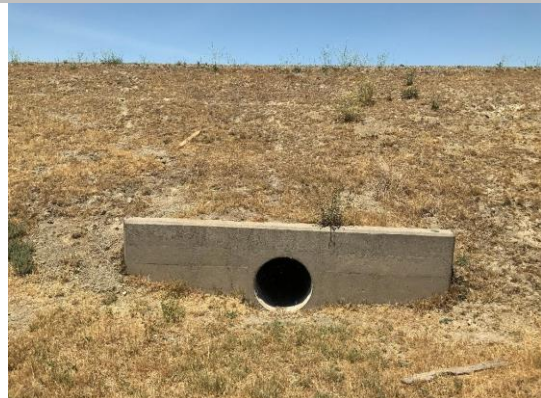
Photo 2 of 3 : UCIP_SP_2024_71177_99547.jpg

LS view: Slope and headwall at toe.

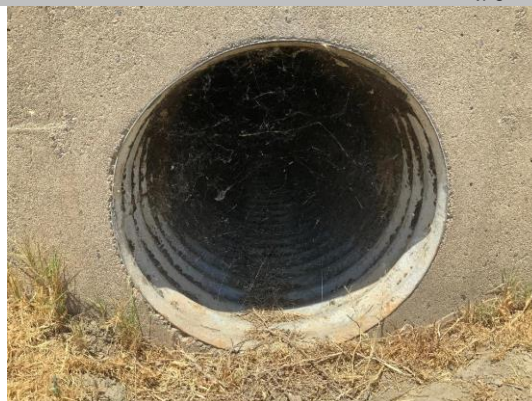
Photo 3 of 3 : UCIP_SP_2024_71177_99548.jpg

LS view: Close up of pipe inlet at toe.

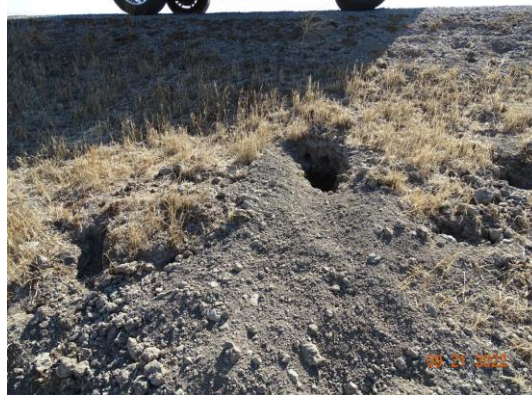
Photo 1 of 1 : SP_2024_NA0010_126_16_20240212_00001.jpg

LM Start	0.49	Rating **	U	Issue No.	16
LM End	0.49	Issue Type +	Ma	Location *	WS
Category	Earthen Levee			GPS Latitude/Longitude	
				Start	End
Item	Animal Control			37.257458°	37.257458°
				-120.763682°	-120.763682°
DWR ID	DWR_NA0010_08_f_2022_16				
Comment Code					
A3 : No rodents visible, but rodent burrows visible; need to backfill and compact or grout burrows.					
Inspector Comment

View of animal holes with large quantities of material displaced. (Fall 2022)

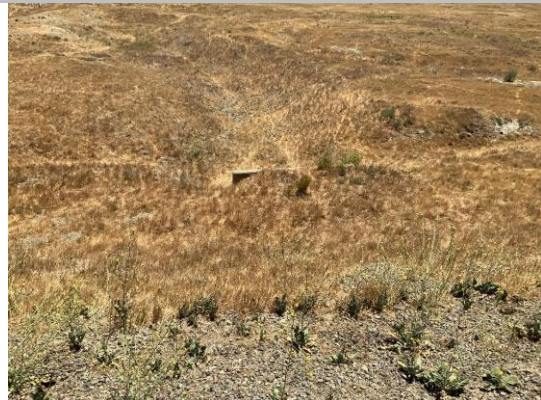
Photo 2 of 3 : UCIP_SP_2024_71178_99554.jpg

LS view: Headwall visible at toe from crown.

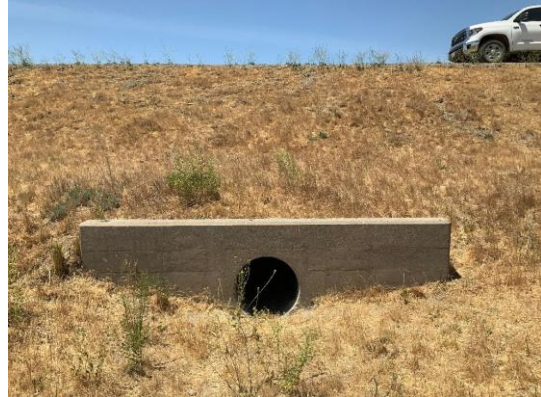
Photo 3 of 3 : UCIP_SP_2024_71178_99555.jpg

LS view: Slope and headwall at toe.

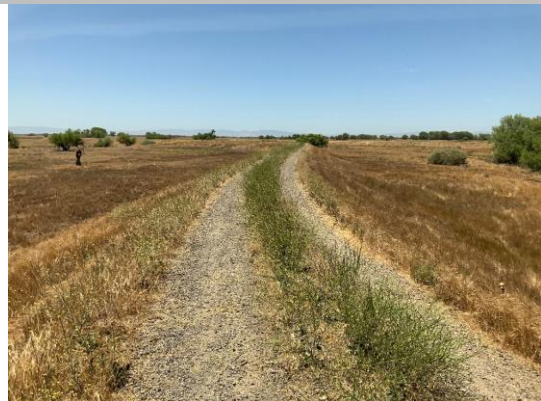
Photo 1 of 3 : UCIP_SP_2024_71179_99560.jpg

DS_ID:19905
 FS_ID:71179
 EP_NO: N/A
 Repair Type: Non-Urgent
 EVAL Issue:
 Crossing Status: Found
 UCIP Comments: 06/2/2021 The record has been upgraded from No Action Needed to Non-Urgent. DWR DMP internal inspection has not found pipe integrity issues. LOF of crossing is less or equal to 4.0. Recommend next video inspection in 5 years. No permit was found authorizing this encroachment. CVFPB will need to review crossing to determine owner. The UCIP inspection was completed with GEI staff, P. Espinoza. (H. Dunn – GEI)
 FIELD_STRUCT_DESC: 24-inch corrugated metal gravity drainage pipe (CMP) through the levee, 10.0 feet below the crown. Flap gate on the waterside (WS) end. Concrete headwall on each end. [Additional Reference(s): DWR Levee Log, 2002, (HLM 0.70). USACE San Joaquin O&M Manual, Unit No. 601, Part No. 1, 1967, Amended in 1978, Revised 20 June 1985, (HLM 0.72). DWR As-Built Specification No. 63-25, Sheet No. 11, 9 May 1963, (HLM 0.72)].

Levee crown looking downstream.

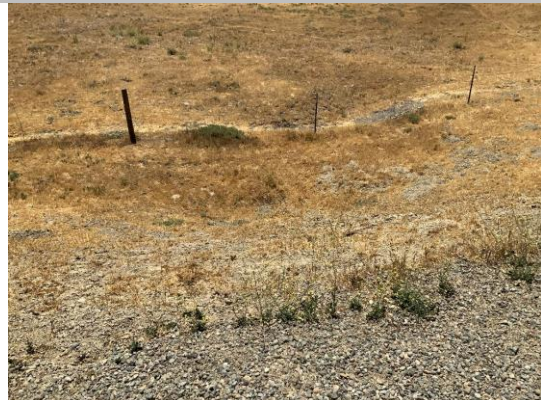
Photo 2 of 3 : UCIP_SP_2024_71180_99568.jpg

LS view: Toe from crown.

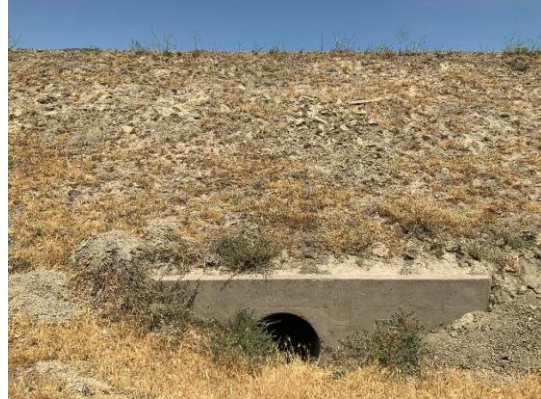
Photo 3 of 3 : UCIP_SP_2024_71180_99569.jpg

LS view: Slope and headwall at toe.

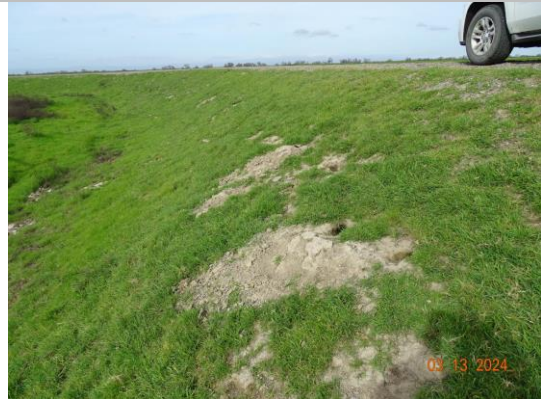
Photo 1 of 1 : SP_2024_NA0010_126_15_20240326_00037.jpg

LM Start	1.02	Rating **	M	Issue No.	15
LM End	1.02	Issue Type +	Ma	Location *	LS
Category	Earthen Levee			GPS Latitude/Longitude	
				Start	End
Item	Animal Control			37.263372°	37.263372°
				-120.758742°	-120.758742°
DWR ID	DWR_NA0010_08_s_2024_15				
Comment Code					
A3 : No rodents visible, but rodent burrows visible; need to backfill and compact or grout burrows.					
Inspector Comment

View of rodent burrows on the landside slope. (Spring 2024)

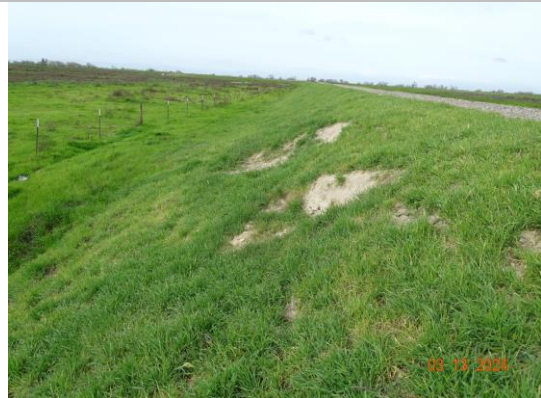
Photo 1 of 1 : SP_2024_NA0010_126_28_20240326_00038.jpg

LM Start	1.21	Rating **	M	Issue No.	28
LM End	1.21	Issue Type +	Ma	Location *	LS
Category	Earthen Levee			GPS Latitude/Longitude	
				Start	End
Item	Erosion / Livestock			37.263179°	37.263179°
				-120.755444°	-120.755444°
DWR ID	DWR_NA0010_08_f_2019_28				
Comment Code					
E4 : Repair the levee slope damaged by livestock and prevent large animal access.					
Inspector Comment

View of damage to the landside slope looking downstream. (Spring 2024)

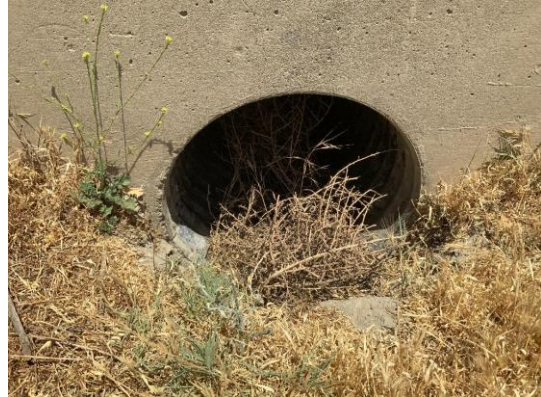
Photo 1 of 1 : UCIP_SP_2024_71181_99576.jpg

Comment Code					
Inspector Comment					
DS_ID:19833 FS_ID:71181 EP_NO: N/A Repair Type: Non-Urgent EVAL Issue: 11, Maintenance Compliance Issue Crossing Status: Found UCIP Comments: 06/2/2021 Record remains Non-Urgent. Some vegetation in LS pipe inlet, recommend clearing out. DWR DMP internal inspection has not found pipe integrity issues. LOF of crossing is less or equal to 4.0. Recommend next video inspection in 5 years. No permit was found authorizing this encroachment. CVFPB will need to review crossing to determine owner. The UCIP inspection was completed with GEI staff, P. Espinoza. (H. Dunn – GEI) 04/16/2014 Debris blocking landward headwall--recommend clearing. (W. Wylie - DWR UCIP) FIELD_STRUCT_DESC: 24-inch corrugated metal gravity drainage pipe (CMP) through the levee, 11.6 feet below the crown. Flap gate on the waterside (WS) end. Concrete headwall on each end. [Additional Reference(s): DWR Levee Log, 2002, (HLM 1.20). USACE San Joaquin O&M Manual, Unit No. 601, Part No. 1, 1967, Amended in 1978, Revised 20 June 1985, (HLM 1.21). DWR As-Built Specification No. 63-25, Sheet No. 11, 9 May 1963, (HLM 1.21)]. FS Date: 6/2/2021

LS view: Close up of pipe inlet at toe, some vegetation inside pipe.

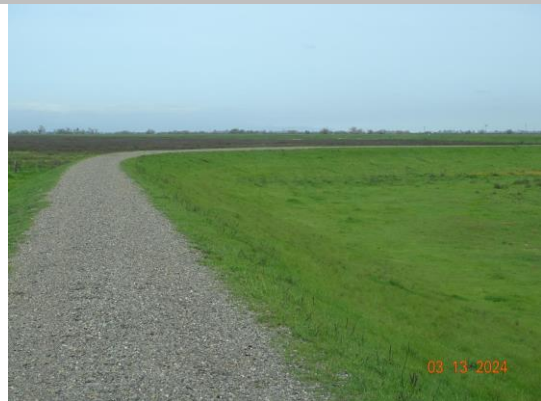
Photo 1 of 1 : SP_2024_NA0010_126_14_20240326_00039.jpg

LM Start	2.01	Rating **	A	Issue No.	14
LM End	2.01	Issue Type +	Ma	Location *	WS
Category	Earthen Levee			GPS Latitude/Longitude	
				Start	End
Item	Vegetation			37.258443 °	37.258443 °
				-120.743543 °	-120.743543 °
DWR ID	DWR_NA0010_08_s_2024_14				
Comment Code					
V1 : Control annual grass and weeds on the levee slopes and easements.					
Inspector Comment

View of the waterside slope looking downstream. (Spring 2024)

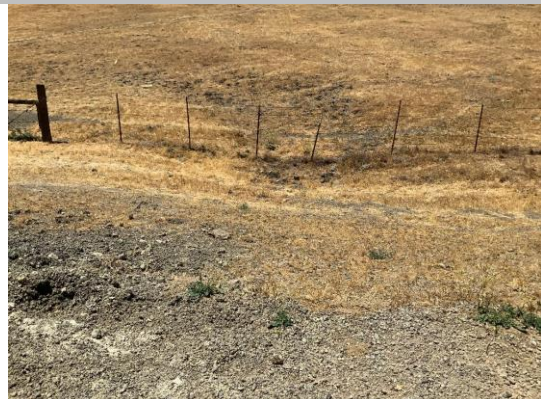
Photo 2 of 3 : UCIP_SP_2024_71183_99587.jpg

LS view: Toe from crown, no pipe visible.

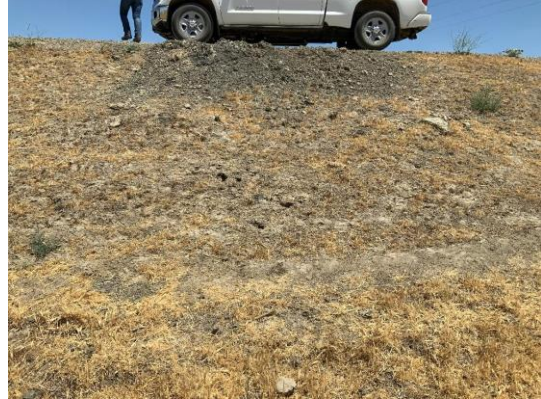
Photo 3 of 3 : UCIP_SP_2024_71183_99588.jpg

LS view: Slope from toe, no pipe visible.

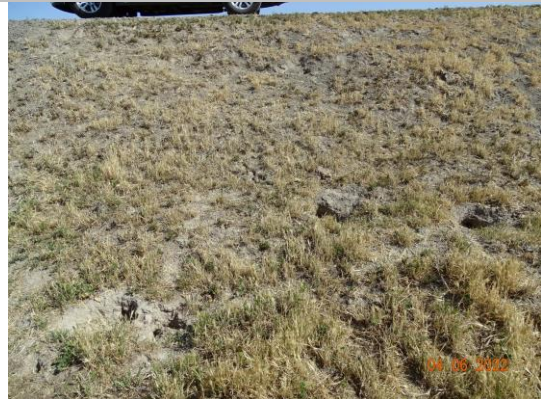
Photo 1 of 1 : SP_2024_NA0010_126_25_20240212_00004.jpg

LM Start	2.07	Rating **	A/W	Issue No.	25
LM End	2.07	Issue Type +	Ma	Location *	LS
Category	Earthen Levee			GPS Latitude/Longitude	
				Start	End
Item	Animal Control			37.258059°	37.258059°
				-120.742451°	-120.742451°
DWR ID	DWR_NA0010_08_f_2019_25				
Comment Code					
A1 : Exterminate rodents and backfill and compact or grout burrows.					
Inspector Comment

Looking uphill at rodent holes in the landside slope. (Spring 2022)

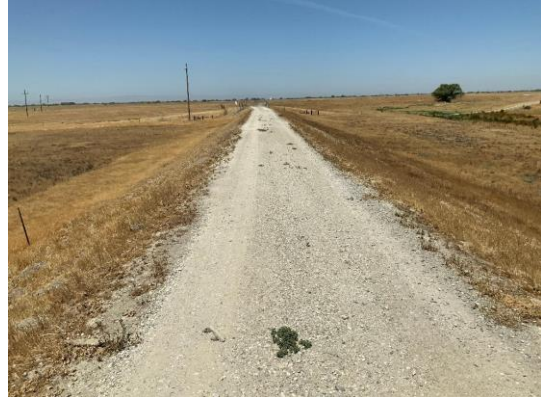
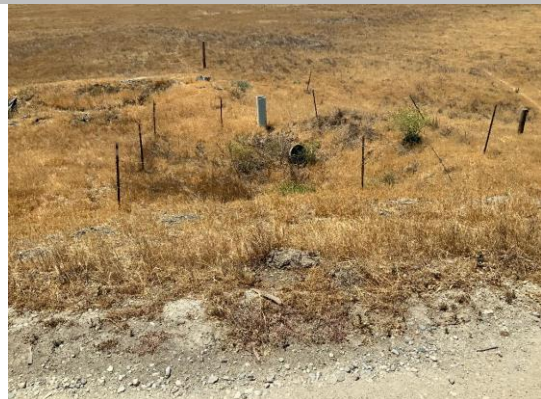
Comment Code					
Inspector Comment					
DS_ID:19836 FS_ID:71184 EP_NO: N/A Repair Type: Non-Urgent EVAL Issue: Crossing Status: Found UCIP Comments: 06/2/2021 The record remains Non-Urgent. DWR DMP internal inspection has not found pipe integrity issues. LOF of crossing is less or equal to 4.0. Recommend next video inspection in 5 years. New 6 inch plastic riser with flowmeter and 24 inch metal pipe underground off the LS toe, directly opposite of the LS pipe inlet of this DSID. No permit was found authorizing this encroachment. CVFPB will need to review crossing to determine owner. The UCIP inspection was completed with GEI staff, P. Espinoza. (H. Dunn – GEI) 04/16/2014 Sediment buildup in pipe visible from landward side. (W. Wylie - DWR UCIP) FIELD_STRUCT_DESC: 24-inch corrugated metal gravity drainage pipe (CMP) through the levee, 9.5 feet below the crown. Flap gate on the waterside (WS) end. Concrete headwall on each end. [Additional Reference(s): DWR Levee Log, 2002, (HLM 2.12). USACE San Joaquin O&M Manual, Unit No. 601, Part No. 1, 1967, Amended in 1978, Revised 20 June 1985, (HLM 2.12). DWR As-Built Specification No. 63-25, Sheet No. 12, 9 May 1963, (HLM 2.12)]. FS Date: 6/2/2021

Levee crown looking downstream.

LS view: Toe from crown.

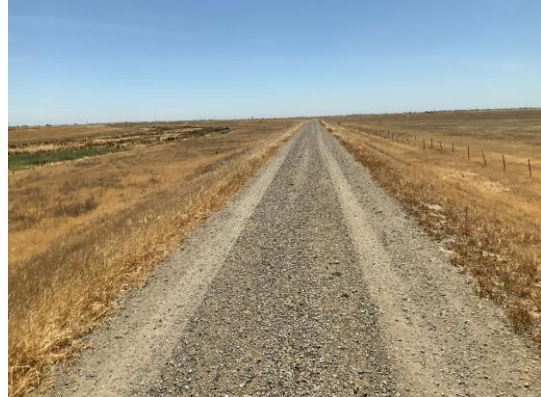
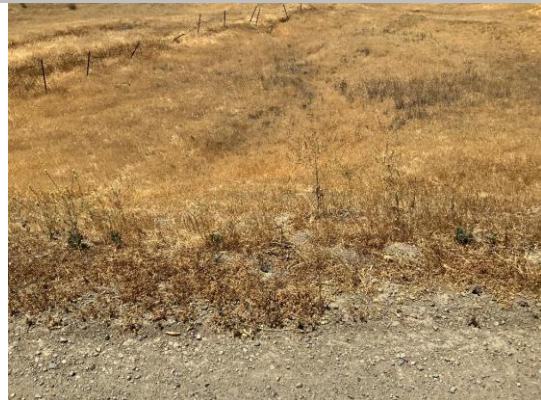
Comment Code					
Inspector Comment					
DS_ID:19837 FS_ID:71185 EP_NO: N/A Repair Type: Non-Urgent EVAL Issue: Crossing Status: Found UCIP Comments: 06/2/2021 The record has been upgraded from No Action Needed to Non-Urgent. DWR DMP internal inspection has not found pipe integrity issues. LOF of crossing is less or equal to 4.0. Recommend next video inspection in 5 years. No permit was found authorizing this encroachment. CVFPB will need to review crossing to determine owner. The UCIP inspection was completed with GEI staff, P. Espinoza. (H. Dunn – GEI) FIELD_STRUCT_DESC: 24-inch corrugated metal gravity drainage pipe (CMP) through the levee, 10.5 feet below the crown. Flap gate on the waterside (WS) end. Concrete headwall on each end. [Additional Reference(s): DWR Levee Log, 2002, (HLM 2.77). USACE San Joaquin O&M Manual, Unit No. 601, Part No. 1, 1967, Amended in 1978, Revised 20 June 1985, (HLM 2.77). DWR As-Built Specification No. 63-25, Sheet No. 13, 9 May 1963, (HLM 2.77)]. FS Date: 6/2/2021

Levee crown looking downstream.

LS view: Toe from crown.

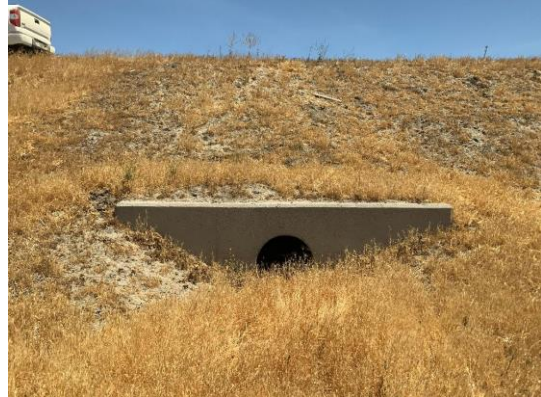
Photo 3 of 3 : UCIP_SP_2024_71185_99606.jpg

LS view: Slope and headwall at toe.

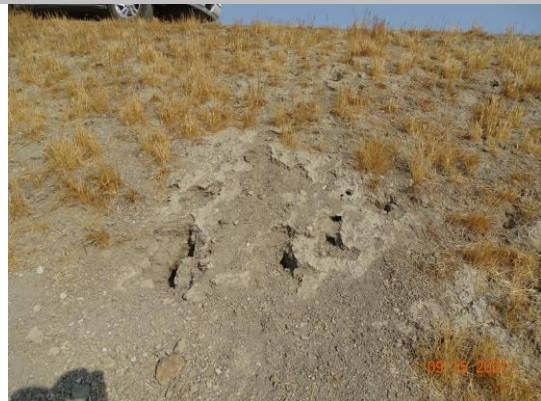
Photo 1 of 1 : SP_2024_NA0010_126_17_20240212_00002.jpg

LM Start	3.28	Rating **	A/W	Issue No.	17
LM End	3.28	Issue Type +	Ma	Location *	LS
Category	Earthen Levee			GPS Latitude/Longitude	
				Start	End
Item	Animal Control			37.252537°	37.252537°
				-120.724795°	-120.724795°
DWR ID	DWR_NA0010_08_f_2021_17				
Comment Code					
A3 : No rodents visible, but rodent burrows visible; need to backfill and compact or grout burrows.					
Inspector Comment

View of animal burrows in the landside slope. (Fall 2021)

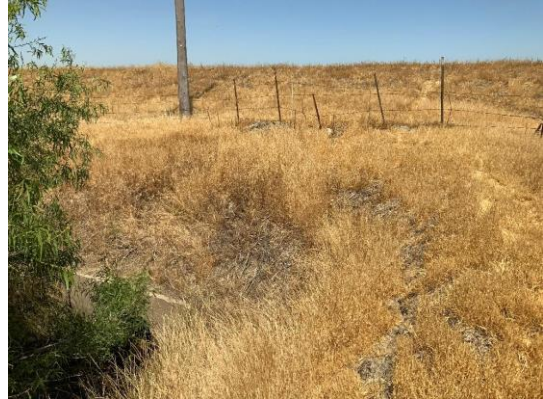
Photo 3 of 3 : UCIP_SP_2024_71188_99626.jpg

Comment Code					
Inspector Comment					
DS_ID:19840 FS_ID:71188 EP_NO: N/A Repair Type: Non-Urgent EVAL Issue: Crossing Status: Found UCIP Comments: 06/2/2021 Record remains Non-Urgent. LS pipe inlet blocked by barbed wire and both ends blocked by water, so limited inspection was done. No permit was found authorizing this encroachment. CVFPB will need to review crossing to determine owner. The UCIP inspection was completed with GEI staff, P. Espinoza. (H. Dunn – GEI) 04/16/2014 No access available on landward side. Need to confirm status of crossing. (W. Wylie - DWR UCIP) FIELD_STRUCT_DESC: 24-inch corrugated metal gravity drainage pipe (CMP) through the levee, 13.0 feet below the crown. Flap gate on the waterside (WS) end. Concrete headwall on each end. [Additional Reference(s): DWR Levee Log, 2002, (HLM 3.43). USACE San Joaquin O&M Manual, Unit No. 601, Part No. 1, 1967, Amended in 1978, Revised 20 June 1985, (HLM 3.43). DWR As-Built Specification No. 63-25, Sheet No. 13, 9 May 1963, (HLM 3.43)]. FS Date: 6/2/2021

LS view: Slope from toe.

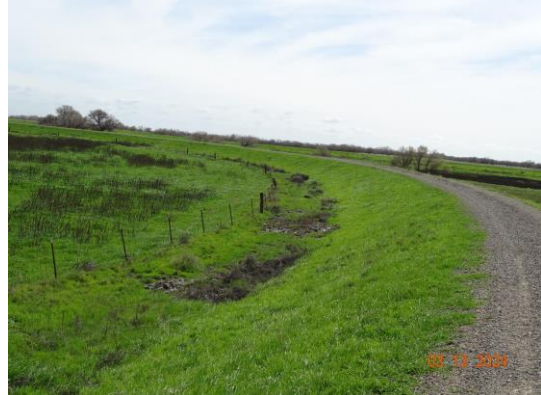
Photo 1 of 1 : SP_2024_NA0010_127_4_20240326_00008.jpg

LM Start	0.05	Rating **	A	Issue No.	4
LM End	0.05	Issue Type +	Ma	Location *	LS
Category	Earthen Levee			GPS Latitude/Longitude	
				Start	End
Item	Vegetation			37.219730 °	37.219730 °
				-120.712440 °	-120.712440 °
DWR ID	DWR_NA0010_09_s_2024_4				
Comment Code					
V1 : Control annual grass and weeds on the levee slopes and easements.					
Inspector Comment

View of vegetation management on the landside slope. (Spring 2024)

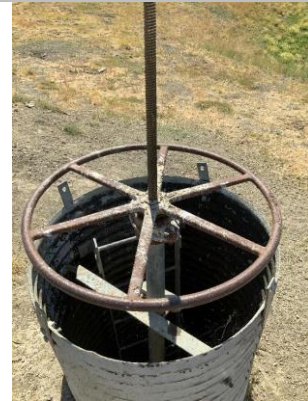
Photo 1 of 1 : UCIP_SP_2024_73203_103172.jpg

Comment Code						
Inspector Comment						
DS_ID:19841 FS_ID:73203 EP_NO: N/A Repair Type: Non-Urgent EVAL Issue: 4b, Safety Issue Crossing Status: Found UCIP Comments: 06/09/2021 The record remains Non-Urgent. Limited inspection of landside (LS) and WS due to water and mud. LS CMP riser has missing lid. WS outlet pipe edges are warped. No permit was found authorizing this encroachment. CVFPB will need to review crossing to determine owner. The UCIP inspection was completed with GEI staff, H.Dunn. (P.Espinoza – GEI) 04/22/2014 Concrete headwalls on landward and waterward under water. Need photo to confirm condition of concrete headwalls, pipe, and gate on both toes. (W. Wylie - DWR UCIP) FIELD_STRUCT_DESC: 24-inch corrugated metal gravity drainage pipe (CMP) through the levee, 18.7 feet below the crown. Slide gate in a 36-inch CMP riser unit on the waterside (WS) slope. Concrete U-shaped headwall on each end. [Additional Reference(s): DWR Levee Log, 2002, (HLM 0.48). USACE San Joaquin O&M Manual, Unit No. 601, Part No. 1, 1967, Amended in 1978, Revised 20 June 1985, (HLM 0.47). DWR As-Built Specification No. 63-25, Sheet No. 14, 9 May 1963, (HLM 0.47)]. FS Date: 6/9/2021 2:41:00 PM

WS view: Close-up of slide gate in CMP riser on slope.

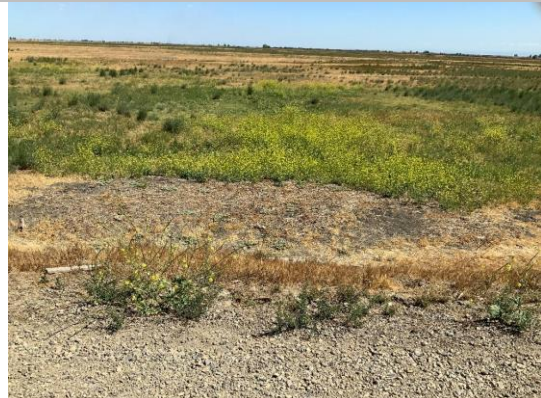
Comment Code						
Inspector Comment						
DS_ID:19842 FS_ID:73202 EP_NO: N/A Repair Type: Non-Urgent EVAL Issue: Crossing Status: Found UCIP Comments: 06/09/2021 The record remains Non-Urgent. DWR DMP internal inspection has not found pipe integrity issues. LOF of crossing is less or equal to 4.0. Recommend next video inspection in 5 years. No permit was found authorizing this encroachment. CVFPB will need to review crossing to determine owner. The UCIP inspection was completed with GEI staff, H.Dunn. (P.Espinoza – GEI) 04/22/2014 Animal burrows in area on LS slope. Minor sediment buildup in pipe visible on landward side--recommend clearing. (W. Wylie - DWR UCIP) FIELD_STRUCT_DESC: 24-inch corrugated metal gravity drainage pipe (CMP) through the levee, 8.7 feet below the crown. Flap gate on the waterside (WS) end. Concrete headwall on the landside (LS) end. Concrete U-shaped headwall on the WS end. [Additional Reference(s): DWR Levee Log, 2002, (HLM 0.70). USACE San Joaquin O&M Manual, Unit No. 601, Part No. 1, 1967, Amended in 1978, Revised 20 June 1985, (HLM 0.70). DWR As-Built Specification No. 63-25, Sheet No. 14, 9 May 1963, (HLM 0.70)]. FS Date: 6/9/2021

View of levee crown.

LS view: Slope from crown.

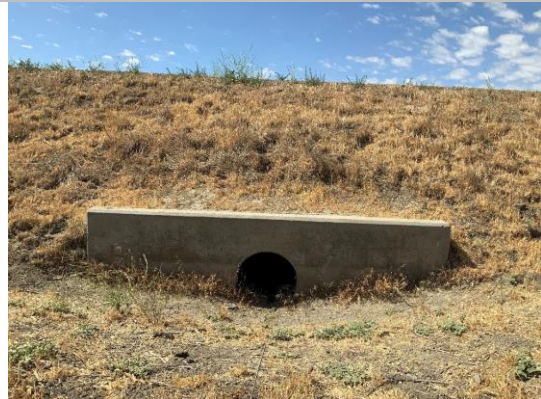
Photo 3 of 3 : UCIP_SP_2024_73202_103235.jpg

LS view: Concrete headwall and inlet pipe at toe.

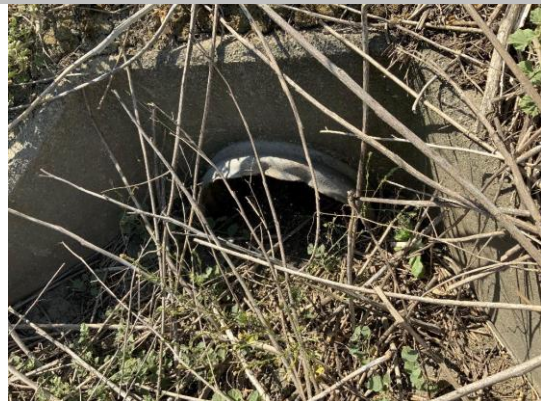
Photo 1 of 2 : UCIP_SP_2024_73200_103189.jpg

DS_ID:19843
FS_ID:73200
EP_NO: N/A
Repair Type: Non-Urgent
EVAL Issue: 4b, Safety Issue
Crossing Status: Found
UCIP Comments: 06/09/2021 The record has been upgraded from No Action Needed to Non-Urgent. No cover or handle on CMP riser on WS slope. Water in riser shows evidence that flapgate is open. Outlet pipe on WS toe not found. Dense vegetation and sediment limits inspectors ability to identify signs of inlet pipe condition on LS toe recommend removal of vegetation and sediment. LS inlet pipe appears to have slight warping around edges. No permit was found authorizing this encroachment. CVFPB will need to review crossing to determine owner. The UCIP inspection was completed with GEI staff, H.Dunn. (P.Espinoza – GEI)
FIELD_STRUCT_DESC: [Crane Irrigation Structure] 24-inch corrugated metal gravity drainage pipe (CMP) through the levee, 9.7 feet below the crown. Two slide gates in a 48-inch CMP riser unit on the waterside (WS) slope. Concrete U-shaped headwall on the landside (LS) end. WS end cobble revetted on the bank and in the outlet drain. [Additional Reference(s): DWR Levee Log, 2002, (HLM 0.87). USACE San Joaquin O&M Manual, Unit No. 601, Part No. 1, 1967, Amended in 1978, Revised 20 June 1985, (HLM 0.87). DWR As-Built Specification No. 63-25, Sheet No. 14, 9 May 1963, (HLM 0.87)].

LS view: concrete headwall and inlet at LS toe.
