Flood Control Project Maintenance
Levee Inspections
LMA District Cover Sheet

Lower San Joaquin Levee District

**Flood Control Project Maintenance
Levee Inspections
Unit Cover Sheet**

Levee Inspection Report By Mile - Spring 2024

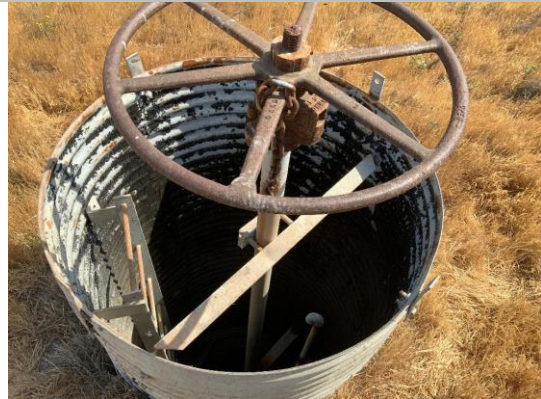
Photo 1 of 1 : UCIP_SP_2024_81002_103402.jpg

DS_ID:19845
FS_ID:81002
EP_NO: N/A
Repair Type: Urgent
EVAL Issue: 1, Pipe Integrity
Crossing Status: Found
UCIP Comments: 09/15/2023 Record updated from Non-Urgent to Urgent. DMP internal video inspection has found severe pipe defects. Crossing will be monitored until funding becomes available to address the issues. (O. Yakimov - DWR UCIP)
06/09/2021 The record remains Non-Urgent. No cover on CMP riser on WS slope, creating a safety hazard. Limited inspection of inlet pipe on LS and outlet pipe on WS due to elevated water levels around the headwalls and inlet/outlets, limiting the ability to inspect pipes at a close proximity. No permit was found authorizing this encroachment. CVFPB will need to review crossing to determine owner. The UCIP inspection was completed with GEI staff, H.Dunn. (P.Espinoza – GEI)
04/22/2014 Inlet blocked at LS toe by wooden gate. Need to contact owner to determine status. (W. Wylie - DWR UCIP)

FIELD_STRUCT_DESC: 36-inch corrugated metal gravity drainage pipe (CMP) through the levee, 19.6 feet below the crown. Slide gate in a 48-inch CMP riser unit on the waterside (WS) slope. Concrete U-shaped headwall on each end. [Additional Reference(s): DWR Levee Log, 2002, (HLM 0.31). USACE San Joaquin O&M Manual, Unit No. 601, Part No. 1, 1967, Amended in 1978, Revised 20 June 1985, (HLM 0.31). DWR As-Built Specification No. 63-25, Sheet No. 14, 9 May 1963, (HLM 0.31)].
FS Date: 6/9/2021 11:34:00 AM

WS view: Closeup of CMP riser with slidegate on slope.

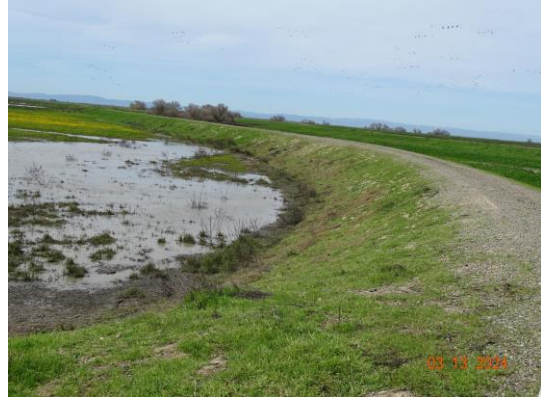
Photo 1 of 1 : SP_2024_NA0010_128_3_20240326_00003.jpg

LM Start	0.44	Rating **	A	Issue No.	3
LM End	0.44	Issue Type +	Ma	Location *	LS
Category	Earthen Levee			GPS Latitude/Longitude	
				Start	End
Item	Vegetation			37.219687°	37.219687°
				-120.704115°	-120.704115°
DWR ID	DWR_NA0010_10_s_2024_3				
Comment Code					
V1 : Control annual grass and weeds on the levee slopes and easements.					
Inspector Comment

View of the landside slope vegetation management. (Spring 2024)

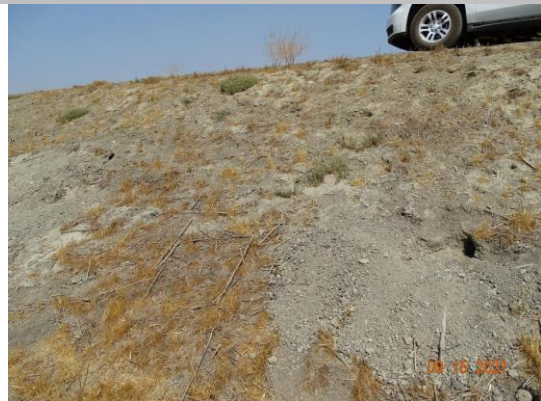
Photo 1 of 1 : SP_2024_NA0010_128_2_20240212_00001.jpg

LM Start	0.51	Rating **	M	Issue No.	2
LM End	0.51	Issue Type +	Ma	Location *	LS
Category	Earthen Levee			GPS Latitude/Longitude	
				Start	End
Item	Animal Control			37.219268°	37.219268°
				-120.703046°	-120.703046°
DWR ID	DWR_NA0010_10_f_2021_2				
Comment Code					
A3 : No rodents visible, but rodent burrows visible; need to backfill and compact or grout burrows.					
Inspector Comment

View of squirrel holes on the landside slope. (Fall 2021)

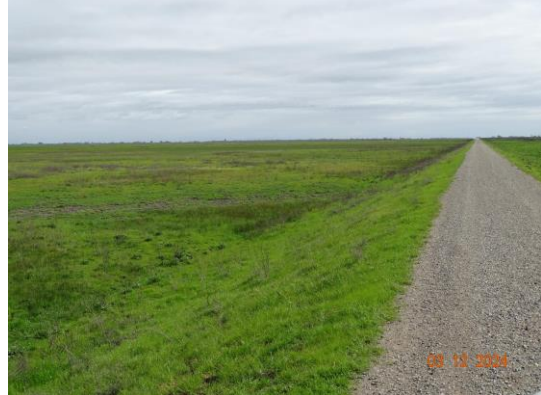
Photo 1 of 1 : SP_2024_NA0010_129_14_20240326_00028.jpg

LM Start	0.02	Rating **	A	Issue No.	14
LM End	0.02	Issue Type +	Ma	Location *	LS
Category	Earthen Levee			GPS Latitude/Longitude	
				Start	End
Item	Vegetation			37.202738°	37.202738°
				-120.754910°	-120.754910°
DWR ID	DWR_NA0010_11_s_2024_14				
Comment Code					
V1 : Control annual grass and weeds on the levee slopes and easements.					
Inspector Comment

View of the landside slope vegetation mangement. (Spring 2024)

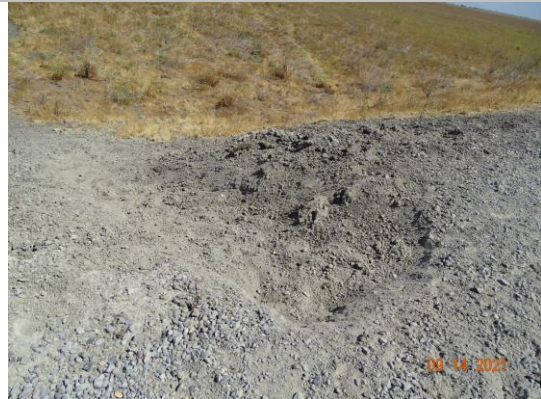
Photo 1 of 1 : SP_2024_NA0010_129_10_20240212_00002.jpg

LM Start	0.16	Rating **	A/W	Issue No.	10
LM End	0.16	Issue Type +	Ma	Location *	LS
Category	Earthen Levee			GPS Latitude/Longitude	
				Start	End
Item	Erosion / Livestock			37.202730°	37.202730°
				-120.752270°	-120.752270°
DWR ID	DWR_NA0010_11_f_2018_10				
Comment Code					
E4 : Repair the levee slope damaged by livestock and prevent large animal access.					
Inspector Comment					
Damage has been repaired. Suggest monitoring for settlement.

View of livestock damage to the landside slope. (Fall 2021)

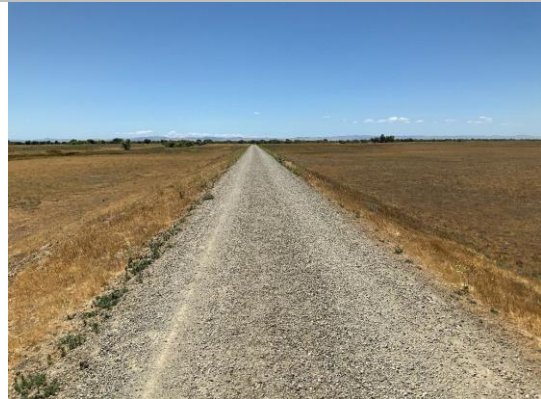
LM Start	0.42	Rating **	M	Issue No.	18	
LM End	0.42	Issue Type +	Ma	Location *		
Category	Supplemental			GPS Latitude/Longitude		
				Start		End
Item	DWR UCIP LMA Responsibility			37.202754°		37.202754°
				-120.747689°		-120.747689°
DWR ID	19846

Comment Code						
Inspector Comment						
DS_ID:19846 FS_ID:73267 EP_NO: N/A Repair Type: Non-Urgent EVAL Issue: Crossing Status: Found UCIP Comments: 06/8/2021 The record remains Non-Urgent. WS pipe end either completely buried under dirt or has been removed. Only riser visible on WS slope, pipe end not visible at all. Recommend contacting owner to determine status of pipe. No permit was found authorizing this encroachment. CVFPB will need to review crossing to determine owner. The UCIP inspection was completed with GEI staff, P. Espinoza. (H. Dunn- GEI) 04/18/201 Need to contact owner. Recommend clearing sediment deposit inside pipe. (O. Magana - DWR UCIP) FIELD_STRUCT_DESC: 24-inch corrugated metal gravity drainage pipe (CMP) through the levee, 11.0 feet below the crown. Slide gate in a CMP riser unit on the waterside (WS) end. [Additional Reference(s): DWR Levee Log, 2002, (HLM 0.43). USACE San Joaquin O&M Manual, Unit No. 601, Part No. 1, 1967, Amended in 1978, Revised 20 June 1985, (HLM 0.42). DWR As-Built Specification No. 59-01, Sheet No. 61, 10 December 1958, (HLM 0.42)]. FS Date: 6/8/2021

Levee crown looking downstream.

LS view: Toe from crown.

LS view: Slope and headwall at toe.

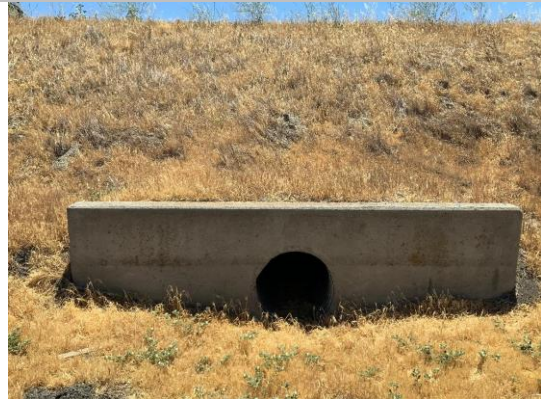
Comment Code						
Inspector Comment						
DS_ID:19847 FS_ID:73268 EP_NO: N/A Repair Type: Non-Urgent EVAL Issue: Crossing Status: Found UCIP Comments: 06/8/2021 The record remains Non-Urgent. DWR DMP internal inspection has not found pipe integrity issues. LOF of crossing is less or equal to 4.0. Recommend next video inspection in 5 years. No permit was found authorizing this encroachment. CVFPB will need to review crossing to determine owner. The UCIP inspection was completed with GEI staff, P. Espinoza. (H. Dunn - GEI) 04/18/201 Need to contact owner. Recommend clearing sediment deposit inside pipe. (O. Magana - DWR UCIP) FIELD_STRUCT_DESC: 24-inch corrugated metal gravity drainage pipe (CMP) through the levee, 10.0 feet below the crown. Flap gate on the waterside (WS) end. [Additional Reference(s): DWR Levee Log, 2002, (HLM 0.65). USACE San Joaquin O&M Manual, Unit No. 601, Part No. 1, 1967, Amended in 1978, Revised 20 June 1985, (HLM 0.65). DWR As-Built Specification No. 59-01, Sheet No. 61, 10 December 1958, (HLM 0.65)]. FS Date: 6/8/2021

Levee crown looking downstream.

LS view: Headwall visible at toe from crown.

LS view: Slope and headwall at toe.

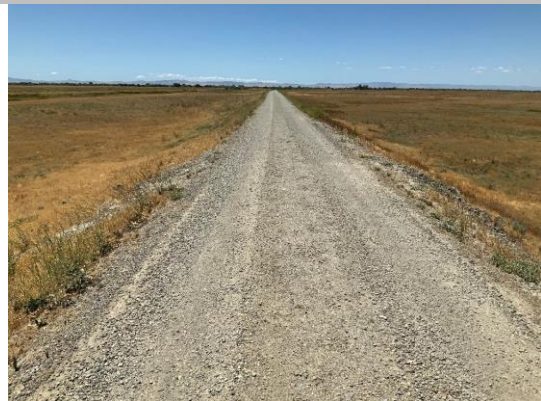
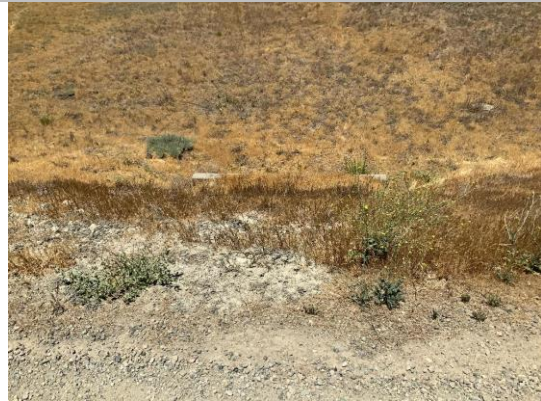
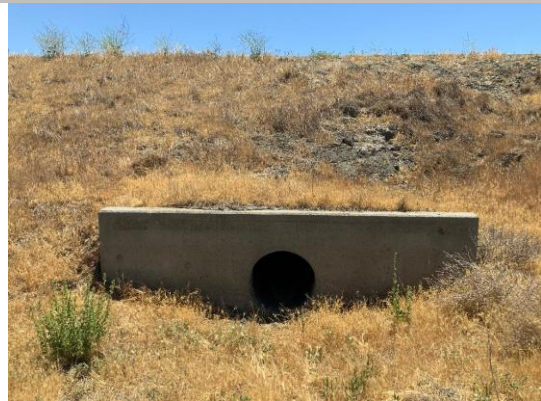
LM Start	0.84	Rating **	M	Issue No.	20
LM End	0.84	Issue Type +	Ma	Location *	
Category	Supplemental			GPS Latitude/Longitude	
				Start	End
Item	DWR UCIP LMA Responsibility			37.202745°	37.202745°
				-120.739935°	-120.739935°
DWR ID	19848

DS_ID:19848
FS_ID:73269
EP_NO: N/A
Repair Type: Non-Urgent
EVAL Issue:
Crossing Status: Found
UCIP Comments: 06/8/2021 The record remains Non-Urgent. DWR DMP internal inspection has not found pipe integrity issues. LOF of crossing is less or equal to 4.0. Recommend next video inspection in 5 years. No permit was found authorizing this encroachment. CVFPB will need to review crossing to determine owner. The UCIP inspection was completed with GEI staff, P. Espinoza. (H. Dunn - GEI) 04/18/201
Need to contact owner. Recommend clearing sediment deposit inside pipe. (O. Magana - DWR UCIP)
FIELD_STRUCT_DESC: 24-inch corrugated metal gravity drainage pipe (CMP) through the levee, 10.3 feet below the crown. Flap gate on the waterside (WS) end. [Additional Reference(s): DWR Levee Log, 2002, (HLM 0.85). USACE San Joaquin O&M Manual, Unit No. 601, Part No. 1, 1967, Amended in 1978, Revised 20 June 1985, (HLM 0.84). DWR As-Built Specification No. 59-01, Sheet No. 61, 10 December 1958, (HLM 0.84)].

Levee crown looking downstream.

LS view: Toe from crown.

LS view: Headwall and slope from toe.

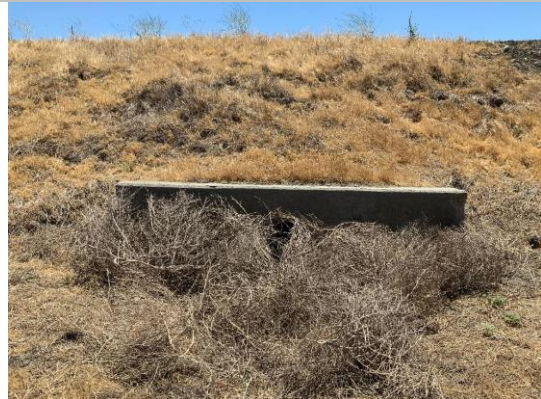
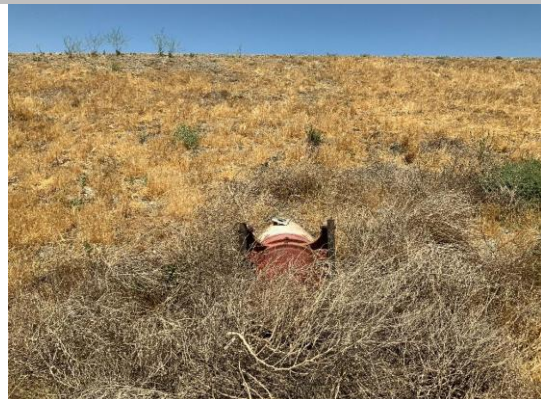
DS_ID:19849
FS_ID:73270
EP_NO: N/A
Repair Type: Non-Urgent
EVAL Issue: 11, Maintenance Compliance Issue
Crossing Status: Found
UCIP Comments: 06/8/2021 The record remains Non-Urgent. DWR DMP internal inspection has not found pipe integrity issues. LOF of crossing is less or equal to 4.0. Recommend next video inspection in 5 years. Dense tumbleweeds blocking both LS and WS ends, recommend removal. No permit was found authorizing this encroachment. CVFPB will need to review crossing to determine owner. The UCIP inspection was completed with GEI staff, P. Espinoza. (H. Dunn - GEI)

LS view: Headwall and slope at toe.

WS view: Flapgate and slope from toe. Dense tumbleweeds at toe.

04/18/2014 Need to contact owner. Recommend clearing sediment deposit inside pipe. (O. Magana - DWR UCIP)
FIELD_STRUCT_DESC: 24-inch corrugated metal gravity drainage pipe (CMP) through the levee, 9.0 feet below the crown. Flap gate on the waterside (WS) end. [Additional Reference(s): DWR Levee Log, 2002, (HLM 1.13). USACE San Joaquin O&M Manual, Unit No. 601, Part No. 1, 1967, Amended in 1978, Revised 20 June 1985, (HLM 1.13). DWR As-Built Specification No. 59-01, Sheet No. 61, 10 December 1958, (HLM 1.13)].
FS Date: 6/8/2021

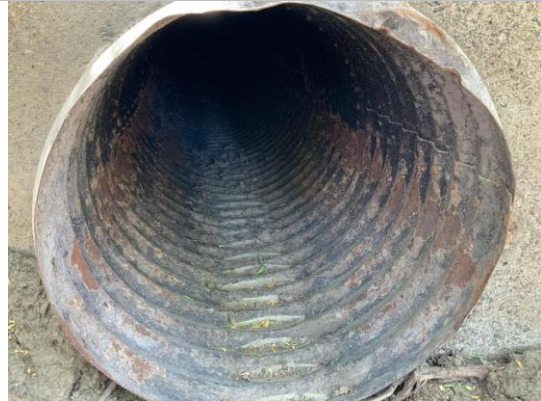
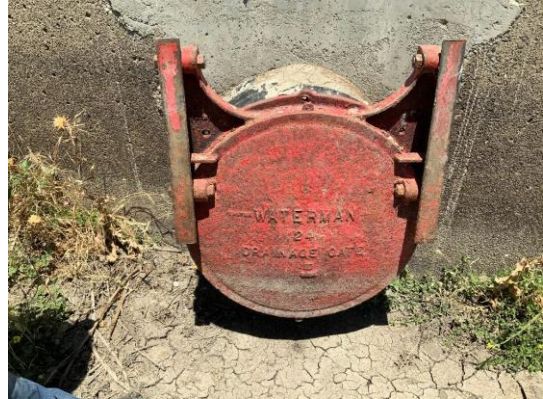
Comment Code						
Inspector Comment						
DS_ID:19852 FS_ID:77932 EP_NO: N/A Repair Type: Non-Urgent EVAL Issue: Crossing Status: Found UCIP Comments: 12/20/2022 Record updated from Urgent to Non-Urgent. Pipe has been CIPP lined. LOF of crossing is less or equal to 4. Recommend next video inspection in 5 years. (O.Yakimov - DWR UCIP) 06/8/2021 The record has been upgraded from Non-Urgent to Urgent. DWR DMP internal inspection has found pipe integrity issues. LOF of crossing is between 5 and 6. Crossing will be monitored until funding becomes available to address the issues. No permit was found authorizing this encroachment. CVFPB will need to review crossing to determine owner. Pipe has since been cleared out of sediment since previous inspection. The UCIP inspection was completed with GEI staff, P. Espinoza. (H. Dunn- GE)04/18/201 Need to contact owner. Recommend clearing sediment deposit inside pipe. (O. Magana - DWR UCIP) FIELD_STRUCT_DESC: 24-inch CIPP-lined corrugated metal gravity drainage pipe (CMP) through the levee, 15.0 feet below the crown. Flap gate on the waterside (WS) end. [Additional Reference(s): DWR Levee Log, 2002, (HLM 3.04). USACE San Joaquin O&M Manual, Unit No. 601, Part No. 1, 1967, Amended in 1978, Revised 20 June 1985, (HLM 3.04). DWR As-Built Specification No. 59-01, Sheet No. 63, 10 December 1958, (HLM 3.04)]. FS Date: 6/8/2021 11:31:05 AM

LS view: Close up of pipe inlet at toe.

WS view: Close up of flapgate at toe.

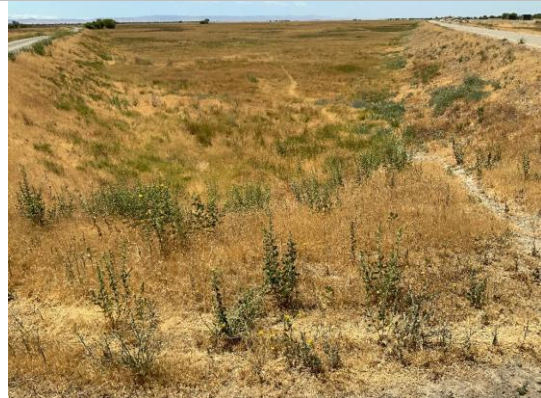
Comment Code						
Inspector Comment						
DS_ID:25542 FS_ID:79244 EP_NO: N/A Repair Type: Non-Urgent EVAL Issue: Crossing Status: Not Found UCIP Comments: 03/13/2023 Updated coordinates of the crossing to match HLM of Unit 11. Needs field verification. (O.Yakimov - DWR UCIP) 06/8/2021 The record is Non-Urgent. Pipe not found by visual inspection. This appears to potentially be inside a different unit based on the CLM since this unit only goes from CLM 0 to 3.31. Either way, it was not observed in the field. Recommend contacting owner to determine status of pipe. No permit was found authorizing this encroachment. CVFPB will need to review crossing to determine owner. The UCIP inspection was completed with GEI staff, P. Espinoza. (H. Dunn- GEI) 09/23/2020 UCIP record brought online. Confirm location. (O. Magana - DWR UCIP) FIELD_STRUCT_DESC: 24-inch corrugated metal gravity drainage pipe (CMP) through the levee, 15.0 feet below the crown. Flap gate on the waterside (WS) end. [Additional Reference(s): DWR Levee Log, 2002, (HLM 3.32). USACE San Joaquin O&M Manual, Unit No. 601, Part No. 1, 1967, Amended in 1978, Revised 20 June 1985, (HLM 3.32). DWR As-Built Specification No. 59-01, Sheet No. 63, 10 December 1958, (HLM 3.32)]. FS Date: 6/8/2021 3:55:26 PM

Levee crown on adjacent unit bisecting this one.

LS view: Slope from toe, no pipe visible.

WS view: Slope from toe, no pipe visible.

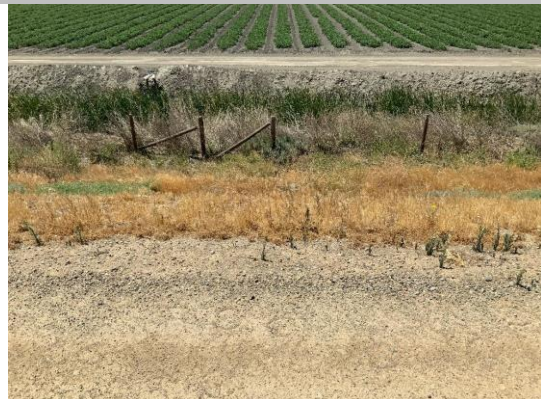
Comment Code					
Inspector Comment					
DS_ID:19855 FS_ID:73304 EP_NO: N/A Repair Type: Non-Urgent EVAL Issue: Crossing Status: Found UCIP Comments: 06/8/2021 The record remains Non-Urgent. DWR DMP internal inspection has not found pipe integrity issues. LOF of crossing is less or equal to 4.0. Recommend next video inspection in 5 years. No permit was found authorizing this encroachment. CVFPB will need to review crossing to determine owner. The UCIP inspection was completed with GEI staff, P. Espinoza. (H. Dunn – GEI) 04/18/2014 Need to contact owner. Dense vegetation limits the inspector's visibility to identify signs of pipe failure (leaks) along the waterward slope. Recommend removing vegetation along pipe alignment to conduct proper inspection of structure. (O. Magana - DWR UCIP) FIELD_STRUCT_DESC: 24-inch corrugated metal gravity drainage pipe (CMP) through the levee, 10.5 feet below the crown. Flap gate on the waterside (WS) end. [Additional Reference(s): DWR Levee Log, 2002, (HLM 0.41). USACE San Joaquin O&M Manual, Unit No. 601, Part No. 1, 1967, Amended in 1978, Revised 20 June 1985, (HLM 0.39). DWR As-Built Specification No. 59-01, Sheet No. 61, 10 December 1958, (HLM 0.39)]. FS Date: 6/8/2021

Levee crown looking downstream.

LS view: Toe from crown.

LS view: Slope from toe.

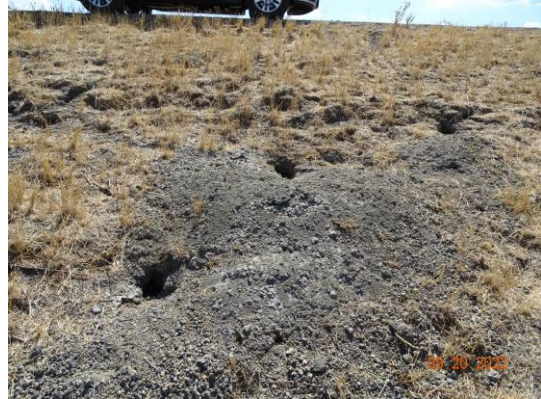
Photo 1 of 1 : SP_2024_NA0010_130_12_20240212_00002.jpg

LM Start	1.05	Rating **	M	Issue No.	12
LM End	1.05	Issue Type +	Ma	Location *	WS
Category	Earthen Levee			GPS Latitude/Longitude	
				Start	End
Item	Animal Control			37.200910°	37.200910°
				-120.736271°	-120.736271°
DWR ID	DWR_NA0010_12_f_2022_12				
Comment Code					
A3 : No rodents visible, but rodent burrows visible; need to backfill and compact or grout burrows.					
Inspector Comment

View of rodent burrows on the waterside slope. (Fall 2022)

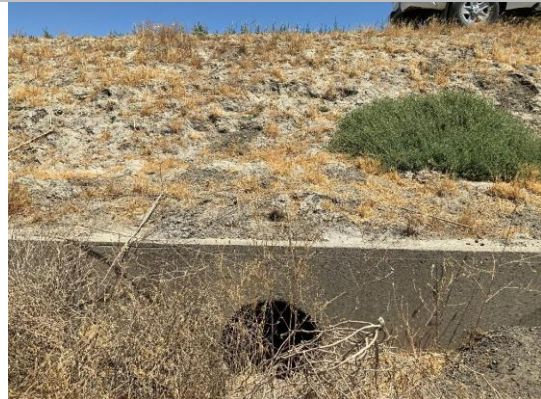
Photo 1 of 2 : UCIP_SP_2024_73305_100631.jpg

Comment Code						
Inspector Comment						
DS_ID:19856						
FS_ID:73305						
EP_NO: N/A						
Repair Type: Non-Urgent						
EVAL Issue: 11, Maintenance Compliance Issue						
Crossing Status: Found						
UCIP Comments: 06/8/2021 The record remains Non-Urgent. DWR						
DMP internal inspection has not found pipe integrity issues. LOF of						
crossing is less or equal to 4.0. Recommend next video inspection in 5						
years. Some vegetation growth starting over WS flapgate and LS pipe						
inlet, recommend removal. No permit was found authorizing this						
encroachment. CVFPB will need to review crossing to determine owner.						
The UCIP inspection was completed with GEI staff, P. Espinoza. (H.						
Dunn – GEI) 04/18/2014 Need to contact owner. Recommend						
clearing sediment deposit inside pipe. (O. Magana - DWR UCIP)						
FIELD_STRUCT_DESC: 24-inch corrugated metal gravity drainage pipe						
(CMP) through the levee, 10.5 feet below the crown. Flap gate on the

LS view: Slope and headwall at toe.

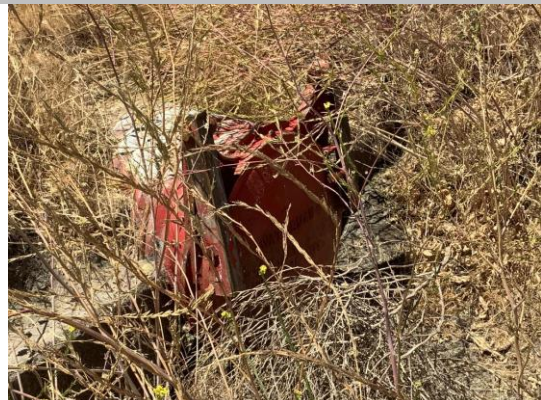
Photo 2 of 2 : UCIP_SP_2024_73305_100636.jpg

WS view: Close up of flapgate at toe.

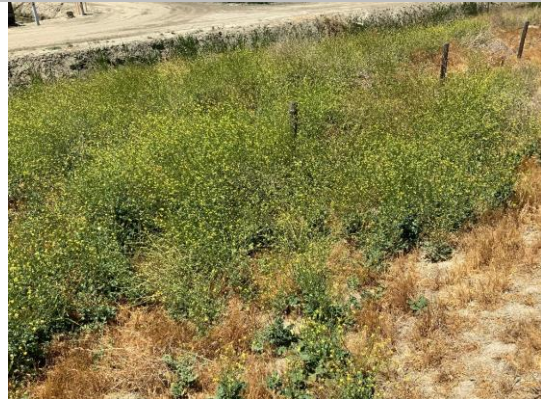
Photo 1 of 2 : UCIP_SP_2024_73306_100638.jpg

DS_ID:19857
FS_ID:73306
EP_NO: N/A
Repair Type: Non-Urgent
EVAL Issue: 11, Maintenance Compliance Issue
Crossing Status: Not Found
UCIP Comments: 06/8/2021 The record remains Non-Urgent. Pipe not found during visual inspection due to dense vegetation on both WS and LS ends. LS end was also blocked off by barbed wire which limited inspection. Recommend removing vegetation in order to assess condition of pipe. No permit was found authorizing this encroachment. CVFPB will need to review crossing to determine owner. The UCIP inspection was completed with GEI staff, P. Espinoza. (H. Dunn – GEI)

04/18/2014 Landward side not accessible due to dense vegetation and fence. Concrete headwall and flap gate under water therefore not able to evaluate condition. Will need to coordinate with owner to evaluate condition of crossing on waterward side and obtain access to evaluate landward side. (O. Magana - DWR UCIP)

LS view: Dense vegetation and barbed wire at the toe, no pipe visible.

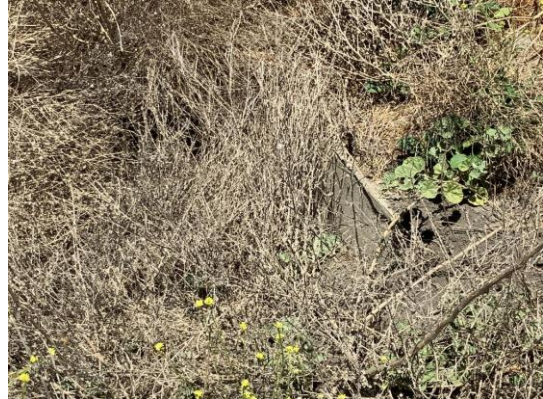
Photo 1 of 1 : UCIP_SP_2024_73307_100645.jpg

Comment Code					
Inspector Comment					
DS_ID:19858 FS_ID:73307 EP_NO: N/A Repair Type: Non-Urgent EVAL Issue: 11, Maintenance Compliance Issue Crossing Status: Found UCIP Comments: 06/8/2021 The record remains Non-Urgent. DWR DMP internal inspection has not found pipe integrity issues. LOF of crossing is less or equal to 4.0. Recommend next video inspection in 5 years. Dense vegetation over LS pipe inlet, headwall barely visible. Recommend removal of vegetation. No permit was found authorizing this encroachment. CVFPB will need to review crossing to determine owner. The UCIP inspection was completed with GEI staff, P. Espinoza. (H. Dunn – GEI) 04/18/2014 Limited access on landward side due to fence and dense vegetation. Recommend obtaining access to landward side and clear vegetation on landward side. (O. Magana - DWR UCIP) FIELD_STRUCT_DESC: 24-inch corrugated metal gravity drainage pipe (CMP) through the levee, 10.7 feet below the crown. Flap gate on the waterside (WS) end. [Additional Reference(s): DWR Levee Log, 2002, (HLM 1.53). USACE San Joaquin O&M Manual, Unit No. 601, Part No. 1, 1967, Amended in 1978, Revised 20 June 1985, (HLM 1.53). DWR As-Built Specification No. 59-01, Sheet No. 62, 10 December 1958, (HLM 1.53)]. FS Date: 6/8/2021

LS view: Headwall barely visible at toe due to dense vegetation.

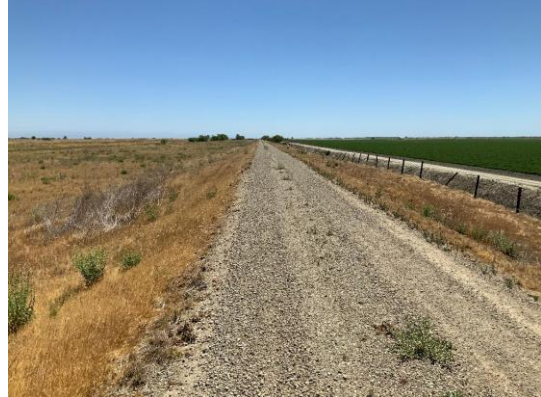
Photo 1 of 3 : UCIP_SP_2024_73308_100655.jpg

Comment Code					
Inspector Comment					
DS_ID:19859 FS_ID:73308 EP_NO: N/A Repair Type: Non-Urgent EVAL Issue: Crossing Status: Found UCIP Comments: 06/8/2021 The record remains Non-Urgent. DWR DMP internal inspection has not found pipe integrity issues. LOF of crossing is less or equal to 4.0. Recommend next video inspection in 5 years. LS pipe inlet inaccessible due to barbed wire, just the top of the headwall visible. No permit was found authorizing this encroachment. CVFPB will need to review crossing to determine owner. The UCIP inspection was completed with GEI staff, P. Espinoza. (H. Dunn – GEI) 04/18/2014 Need to contact owner. Recommend clearing vegetation from landward side--headwall blocked. (O. Magana - DWR UCIP) FIELD_STRUCT_DESC: 24-inch corrugated metal gravity drainage pipe (CMP) through the levee, 14.4 feet below the crown. Flap gate on the waterside (WS) end. [Additional Reference(s): DWR Levee Log, 2002, (HLM 2.16). USACE San Joaquin O&M Manual, Unit No. 601, Part No. 1, 1967, Amended in 1978, Revised 20 June 1985, (HLM 2.16). DWR As-Built Specification No. 59-01, Sheet No. 62, 10 December 1958, (HLM 2.16)]. FS Date: 6/8/2021

Levee crown looking upstream.

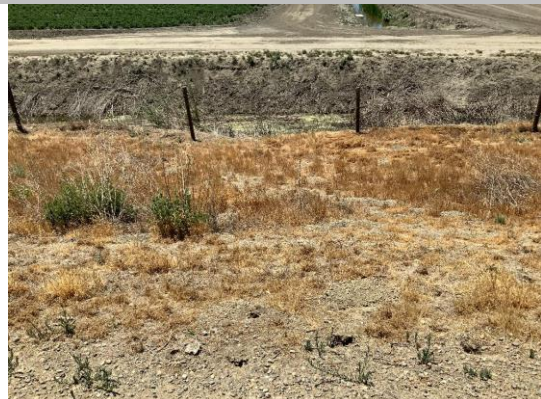
Photo 2 of 3 : UCIP_SP_2024_73308_100659.jpg

LS view: Toe from crown.

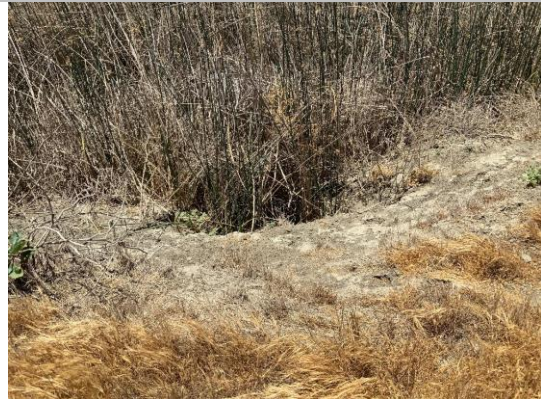
Photo 1 of 1 : UCIP_SP_2024_73310_100669.jpg

DS_ID:19861
FS_ID:73310
EP_NO: N/A
Repair Type: Non-Urgent
EVAL Issue: 11, Maintenance Compliance Issue
Crossing Status: Found
UCIP Comments: 06/8/2021 The record remains Non-Urgent. DWR DMP internal inspection has not found pipe integrity issues. LOF of crossing is less or equal to 4.0. Recommend next video inspection in 5 years. LS pipe inlet inaccessible due to barbed wire and WS flapgate surrounded by water, limited inspection for both. LS pipe inlet also has dense vegetation covering it, recommend removal. No permit was found authorizing this encroachment. CVFPB will need to review crossing to determine owner. The UCIP inspection was completed with GEI staff, P. Espinoza. (H. Dunn – GEI) 11/09/2015 DWR Inspection section confirmed issue has been addressed. Need to coordinate with LMA to determine additional details for extent of repair. (O. Magana - DWR UCIP)04/18/2014 Soil missing behind concrete headwall on waterward side. Unable to determine if missing soil is due to sink holes, rodent activity, or due to erosion. Headwall appears to be leaning slightly forward. Reason why this crossing was labelled urgent was due to the uncertainty of damage to concrete headwall and reason for soil missing behind concrete. Need to coordinate with LMA to determine more information about repair at this location. (O. Magana -DWR UCIP) FIELD_STRUCT_DESC: 24-inch corrugated metal gravity drainage pipe (CMP) through the levee, 2.0 feet below the crown. Flap gate on the waterside (WS) end. [Additional Reference(s): DWR Levee Log, 2002, (HLM 3.00). USACE San Joaquin O&M Manual, Unit No. 601, Part No. 1, 1967, Amended in 1978, Revised 20 June 1985, (HLM 3.00). DWR As-Built Specification No. 59-01, Sheet No. 63, 10 December 1958, (HLM 3.00)].

LS view: Top of headwall visible at toe.

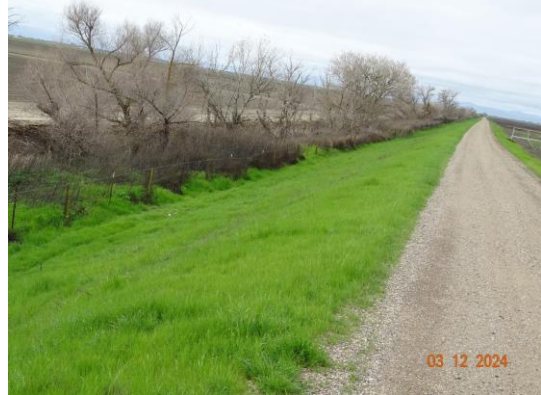
Photo 1 of 1 : SP_2024_NA0010_130_8_20240326_00016.jpg

LM Start	3.28	Rating **	A	Issue No.	8
LM End	3.28	Issue Type +	Ma	Location *	LS
Category	Earthen Levee			GPS Latitude/Longitude	
				Start	End
Item	Vegetation			37.200967°	37.200967°
				-120.695688°	-120.695688°
DWR ID	DWR_NA0010_12_s_ 2024_8				
Comment Code					
V1 : Control annual grass and weeds on the levee slopes and easements.					
Inspector Comment

View of the landside slope looking downstream. (Spring 2024)

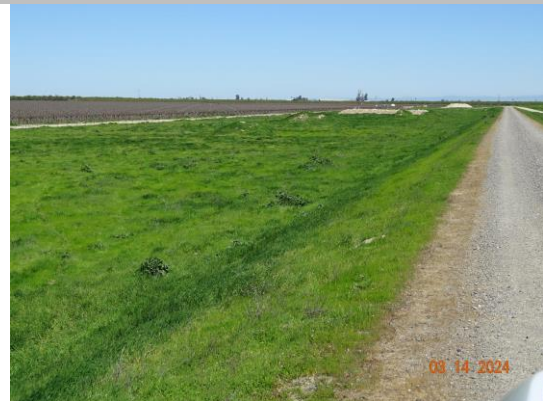
Photo 1 of 1 : SP_2024_NA0010_131_3_20240327_00012.jpg

LM Start	0.03	Rating **	A	Issue No.	3
LM End	0.03	Issue Type +	Ma	Location *	LS
Category	Earthen Levee			GPS Latitude/Longitude	
				Start	End
Item	Vegetation			37.034164°	37.034164°
				-120.441956°	-120.441956°
DWR ID	DWR_NA0010_13_s_2024_3				
Comment Code					
V1 : Control annual grass and weeds on the levee slopes and easements.					
Inspector Comment

View of the vegetation management on the landside slope. (Spring 2024)

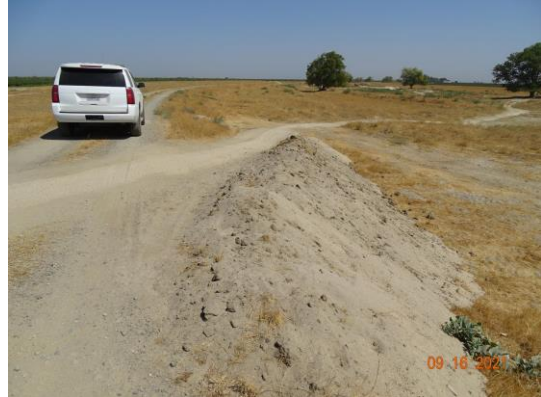
Photo 1 of 1 : SP_2024_NA0010_131_10_20240212_00006.jpg

LM Start	0.48	Rating **	M	Issue No.	10
LM End	0.48	Issue Type +	En	Location *	WS
Category	Earthen Levee			GPS Latitude/Longitude	
				Start	End
Item	Encroachments			37.040347°	37.040347°
				-120.439312°	-120.439312°
DWR ID	DWR_NA0010_13_f_2021_10				
Comment Code					
RA : Ramp					
Inspector Comment

View of unauthorized ramp on the waterside slope. (Fall 2021)

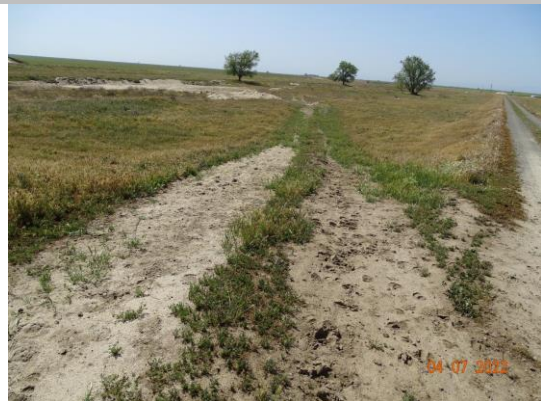
Photo 1 of 1 : SP_2024_NA0010_131_12_20240212_00007.jpg

LM Start	0.72	Rating **	A/W	Issue No.	12
LM End	0.72	Issue Type +	En	Location *	WS
Category	Earthen Levee			GPS Latitude/Longitude	
				Start	End
Item	Encroachments			37.042891°	37.042891°
				-120.436577°	-120.436577°
DWR ID	DWR_NA0010_13_s_2022_12				
Comment Code					
RA : Ramp					
Inspector Comment

Unauthorized ramp constructed on the waterside slope. (Spring 2022)

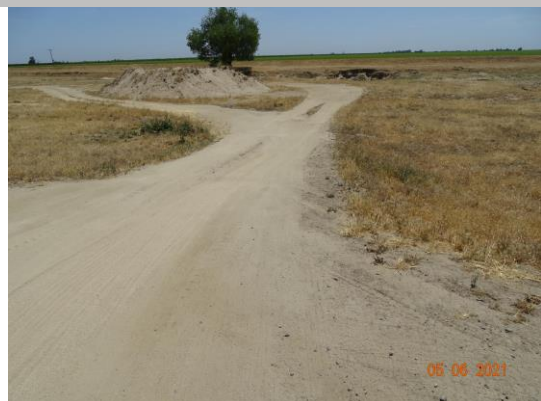
Photo 1 of 1 : SP_2024_NA0010_131_5_20240212_00001.jpg

LM Start	0.91	Rating **	M	Issue No.	5
LM End	0.91	Issue Type +	En	Location *	WS
Category	Earthen Levee			GPS Latitude/Longitude	
				Start	End
Item	Encroachments			37.044855°	37.044855°
				-120.434106°	-120.434106°
DWR ID	DWR_NA0010_13_s_2014_5				
Comment Code					
RA : Ramp					
Inspector Comment					
There is an unauthorized ramp on waterside slope. Access ramp on the landside is shown in as-built drawings.

Unauthorized ramp constructed on the waterside slope. (Spring 2021)

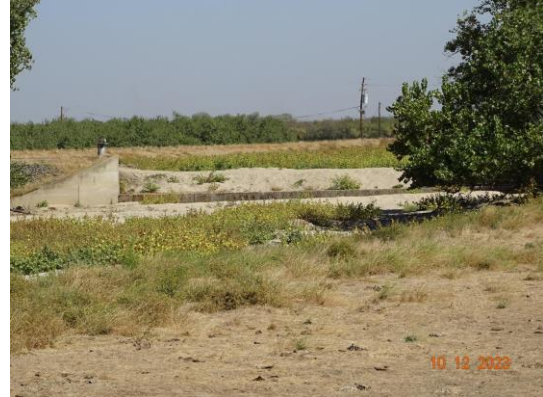
Photo 1 of 2 : SP_2024_NA0010_131_6_20240212_00002.jpg

LM Start	1.14	Rating **	U	Issue No.	6
LM End	1.14	Issue Type +	En	Location *	WS
Category	Earthen Levee			GPS Latitude/Longitude	
				Start	End
Item	Encroachments			37.045541 °	37.045541 °
				-120.430014 °	-120.430014 °
DWR ID	DWR_NA0010_13_f_2015_6				
Comment Code					
WL : Wall					
Inspector Comment					
The sand dam referenced in this issue is an unauthorized construction in the channel by the landowner.

Downstream view of sand dam constructed upstream of the Ash Slough Drop Structure 4. (Fall 2023)

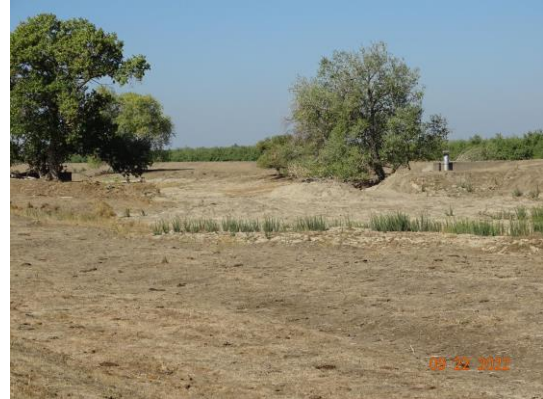
Photo 2 of 2 : SP_2024_NA0010_131_6_20240212_00003.jpg

Upstream view of sand dam. (Fall 2022)

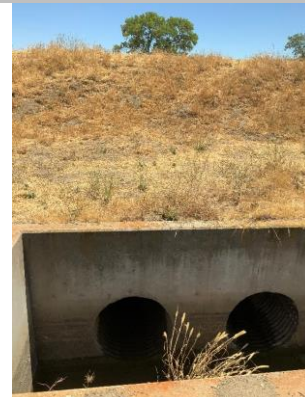
Photo 2 of 3 : UCIP_SP_2024_73336_103418.jpg

LS view: concrete inlet pipe on LS toe.

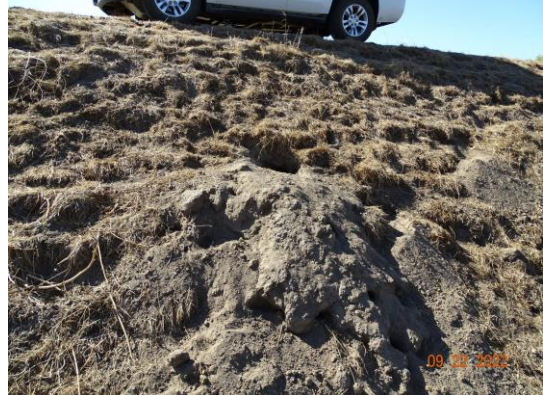
Photo 1 of 1 : SP_2024_NA0010_131_7_20240212_00004.jpg

LM Start	1.21	Rating **	M	Issue No.	7
LM End	1.24	Issue Type +	Ma	Location *	LS
Category	Earthen Levee			GPS Latitude/Longitude	
				Start	End
Item	Animal Control			37.046142°	37.046229°
				-120.428848°	-120.428448°
DWR ID	DWR_NA0010_13_f_2022_7				
Comment Code					
A3 : No rodents visible, but rodent burrows visible; need to backfill and compact or grout burrows.					
Inspector Comment

Several rodent burrows observed in this section. (Fall 2022)

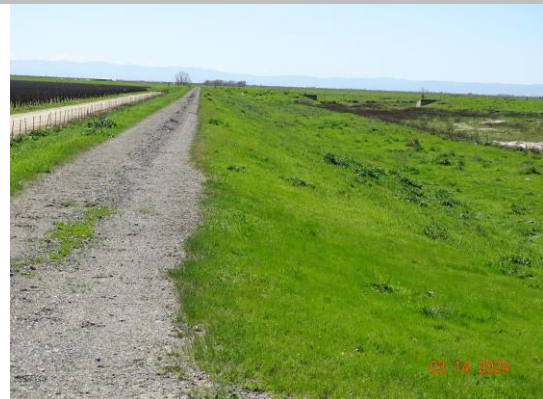
Photo 1 of 1 : SP_2024_NA0010_132_6_20240327_00006.jpg

LM Start	0.33	Rating **	A	Issue No.	6
LM End	0.33	Issue Type +	Ma	Location *	WS
Category	Earthen Levee			GPS Latitude/Longitude	
				Start	End
Item	Vegetation			37.036822°	37.036822°
				-120.439381°	-120.439381°
DWR ID	DWR_NA0010_14_s_2024_6				
Comment Code					
V1 : Control annual grass and weeds on the levee slopes and easements.					
Inspector Comment

View of vegetation on the waterside slope. (Spring 2024)

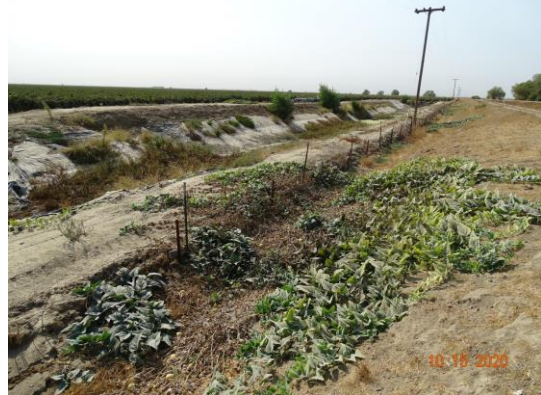
Photo 1 of 1 : SP_2024_NA0010_132_3_20240212_00001.jpg

LM Start	1.15	Rating **	A/W	Issue No.	3
LM End	1.26	Issue Type +	En	Location *	LS
Category	Earthen Levee			GPS Latitude/Longitude	
				Start	End
Item	Encroachments			37.044939°	37.045416°
				-120.429636°	-120.427719°
DWR ID	DWR_NA0010_14_f_2020_3				
Comment Code					
DT : Ditch					
Inspector Comment					
Retention pond dug approx. 20 feet from landside toe. Monitor.

Retention basin dug approximately 20 ft from the landside toe. (Fall 2020)

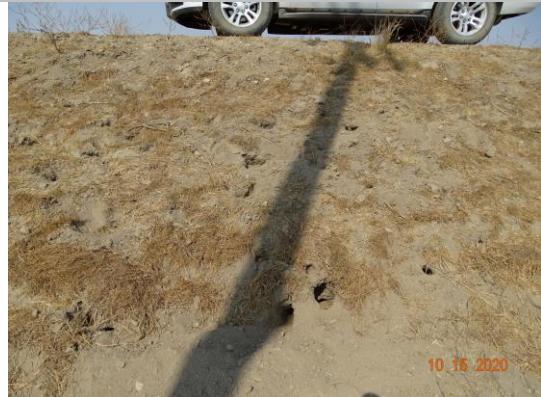
Photo 1 of 1 : SP_2024_NA0010_132_79_20240212_00003.jpg

LM Start	1.24	Rating **	M	Issue No.	79
LM End	1.24	Issue Type +	Ma	Location *	LS
Category	Earthen Levee			GPS Latitude/Longitude	
				Start	End
Item	Animal Control			37.045343°	37.045343°
				-120.428007°	-120.428007°
DWR ID	DWR_NA0010_14_s_2021_79				
Comment Code					
A3 : No rodents visible, but rodent burrows visible; need to backfill and compact or grout burrows.					
Inspector Comment					
Several rodent holes are noted on the landside at this location.

View of rodent burrows on the landside slope. (Fall 2020)

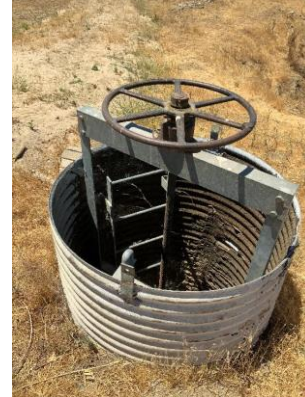
Photo 1 of 1 : UCIP_SP_2024_77924_103812.jpg

Comment Code						
Inspector Comment						
DS_ID:19910 FS_ID:77924 EP_NO: N/A Repair Type: Non-Urgent EVAL Issue: 4b, Safety Issue Crossing Status: Found UCIP Comments: 12/20/2022 Record updated from Urgent to Non-Urgent. Pipe has been CIPP lined. LOF of crossing is less or equal to 4. Recommend next video inspection in 5 years. (O.Yakimov - DWR UCIP) 06/23/2021 Record has been upgraded from No Action Needed to Urgent. DWR DMP internal inspection has found pipe integrity issues. LOF of crossing is between 5 and 6. Crossing will be monitored until funding becomes available to address the issues. Lid missing from CMP riser on WS slope, causing safety concern. LS not accessible; limited inspection due to barbed wire. No permit was found authorizing this encroachment. CVFPB will need to review crossing to determine owner. The UCIP inspection was completed with GEI staff, H.Dunn. (P.Espinoza – GEI) FIELD_STRUCT_DESC: 36-inch CIPP-lined corrugated metal gravity drainage pipe (CMP) through the levee, 9.0 feet below the crown. Slide gate in a 42-inch CMP riser unit on the waterside (WS) slope. Concrete U-shaped headwall on the WS end. Pipe terminates into a concrete ditch on the landside (LS). [Additional Reference(s): DWR Levee Log, 2002, (HLM 1.26). USACE San Joaquin O&M Manual, Unit No. 601, Part No. 1, 1967, Amended in 1978, Revised 20 June 1985, (HLM 1.26). DWR As-Built Specification No. 64-01, Sheet No. 13, 6 November 1963, (HLM 1.26)]. FS Date: 6/23/2021 10:53:01 AM

WS view: close up of CMP riser on slope.

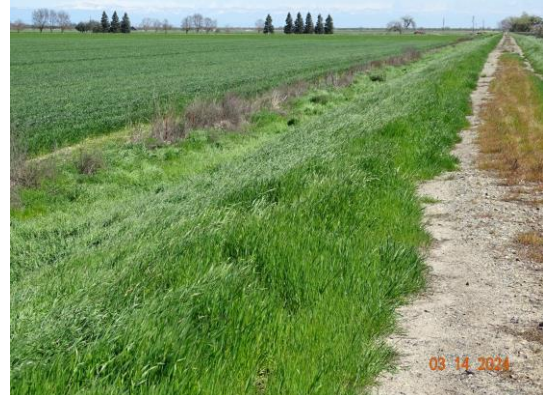
Photo 1 of 1 : SP_2024_NA0010_133_7_20240327_00007.jpg

LM Start	0.73	Rating **	M	Issue No.	7
LM End	2.01	Issue Type +	Ma	Location *	LS
Category	Earthen Levee			GPS Latitude/Longitude	
				Start	End
Item	Vegetation			36.996539°	36.996587°
				-120.397320°	-120.374053°
DWR ID	DWR_NA0010_15_s_2024_7				
Comment Code					
V1 : Control annual grass and weeds on the levee slopes and easements.					
Inspector Comment

View of vegetation on the landside slope. (Spring 2024)

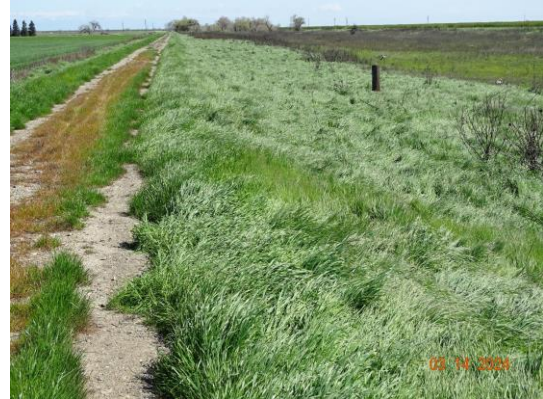
Photo 1 of 1 : SP_2024_NA0010_133_8_20240327_00008.jpg

LM Start	1.52	Rating **	M	Issue No.	8
LM End	2.01	Issue Type +	Ma	Location *	WS
Category	Earthen Levee			GPS Latitude/Longitude	
				Start	End
Item	Vegetation			36.996571°	36.996584°
				-120.382916°	-120.374059°
DWR ID	DWR_NA0010_15_s_2024_8				
Comment Code					
V1 : Control annual grass and weeds on the levee slopes and easements.					
Inspector Comment

Looking upstream along the waterside slope. (Spring 2024)

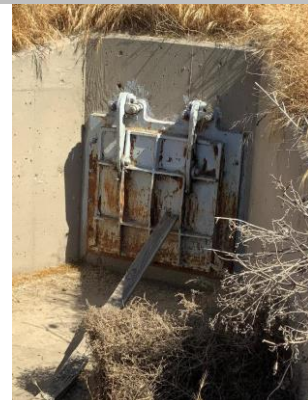
Photo 2 of 2 : UCIP_SP_2024_73367_103833.jpg

WS view: closeup of flapgate.

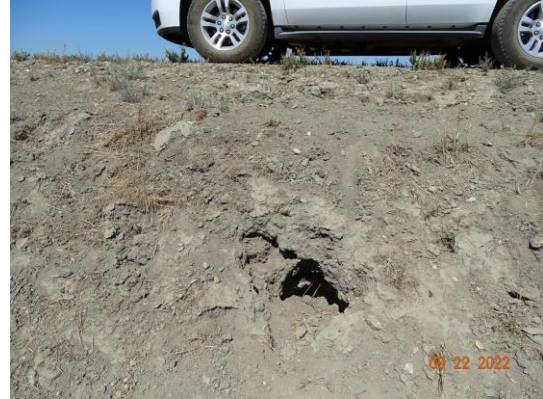
Photo 1 of 1 : SP_2024_NA0010_134_7_20240212_00003.jpg

LM Start	0.22	Rating **	M	Issue No.	7
LM End	0.22	Issue Type +	Ma	Location *	LS
Category	Earthen Levee			GPS Latitude/Longitude	
				Start	End
Item	Animal Control			36.995421°	36.995421°
				-120.404956°	-120.404956°
DWR ID	DWR_NA0010_16_f_2022_7				
Comment Code					
A3 : No rodents visible, but rodent burrows visible; need to backfill and compact or grout burrows.					
Inspector Comment

Animal burrows on the landside slope. (Fall 2022)

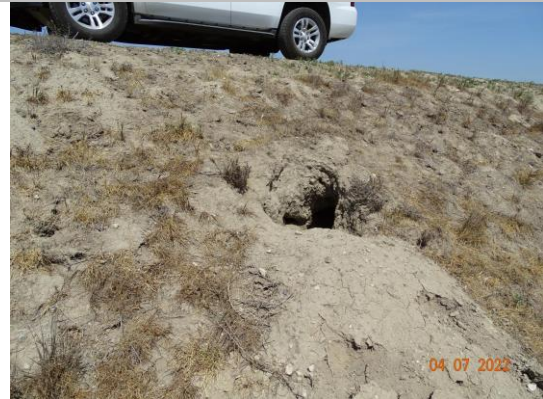
Photo 1 of 1 : SP_2024_NA0010_134_10_20240212_00004.jpg

LM Start	0.30	Rating **	U	Issue No.	10
LM End	0.30	Issue Type +	Ma	Location *	LS
Category	Earthen Levee			GPS Latitude/Longitude	
				Start	End
Item	Animal Control			36.995433°	36.995433°
				-120.403543°	-120.403543°
DWR ID	DWR_NA0010_16_s_2022_10				
Comment Code					
A3 : No rodents visible, but rodent burrows visible; need to backfill and compact or grout burrows.					
Inspector Comment					
Burrow is approximately 18-inches across.

Large animal burrow on the landside slope. (Spring 2022)

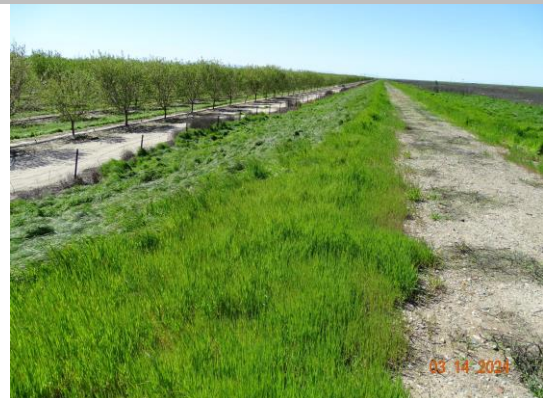
Photo 1 of 1 : SP_2024_NA0010_134_3_20240327_00009.jpg

LM Start	0.76	Rating **	M	Issue No.	3
LM End	1.95	Issue Type +	Ma	Location *	LS
Category	Earthen Levee			GPS Latitude/Longitude	
				Start	End
Item	Vegetation			36.995425°	36.995482°
				-120.395245°	-120.373795°
DWR ID	DWR_NA0010_16_s_2024_3				
Comment Code					
V1 : Control annual grass and weeds on the levee slopes and easements.					
Inspector Comment

View of vegetation on the landside slope. (Spring 2024)

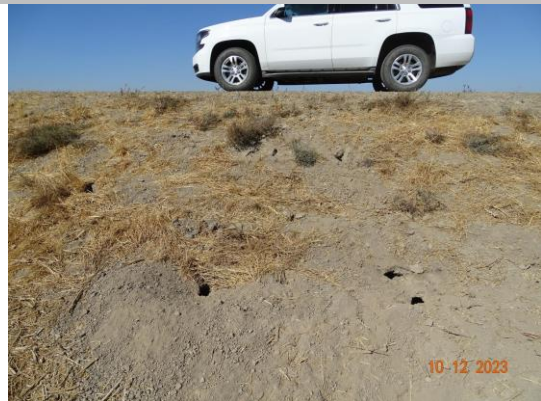
Photo 1 of 1 : SP_2024_NA0010_134_5_20240212_00002.jpg

LM Start	1.27	Rating **	M	Issue No.	5
LM End	1.27	Issue Type +	Ma	Location *	LS
Category	Earthen Levee			GPS Latitude/Longitude	
				Start	End
Item	Animal Control			36.995461°	36.995461°
				-120.386068°	-120.386068°
DWR ID	DWR_NA0010_16_f_2023_5				
Comment Code					
A3 : No rodents visible, but rodent burrows visible; need to backfill and compact or grout burrows.					
Inspector Comment

Multiple rodent burrows in the landside slope. (Fall 2023)

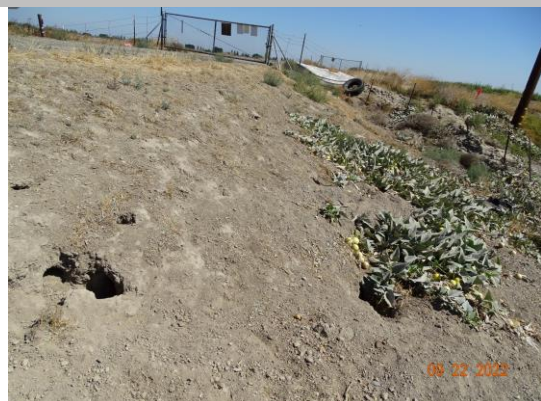
Photo 1 of 1 : SP_2024_NA0010_134_12_20240212_00005.jpg

LM Start	1.41	Rating **	U	Issue No.	12
LM End	1.41	Issue Type +	Ma	Location *	LS
Category	Earthen Levee			GPS Latitude/Longitude	
				Start	End
Item	Animal Control			36.995467°	36.995467°
				-120.383492°	-120.383492°
DWR ID	DWR_NA0010_16_s_2022_12				
Comment Code					
A3 : No rodents visible, but rodent burrows visible; need to backfill and compact or grout burrows.					
Inspector Comment

Large rodent holes in the landside slope. (Fall 2022)

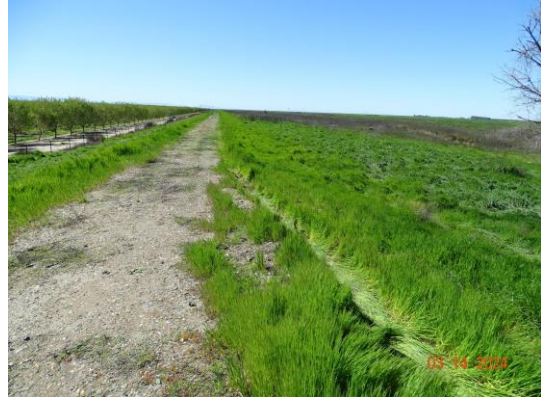
Photo 1 of 1 : SP_2024_NA0010_134_6_20240327_00010.jpg

LM Start	1.42	Rating **	M	Issue No.	6
LM End	1.95	Issue Type +	Ma	Location *	WS
Category	Earthen Levee			GPS Latitude/Longitude	
				Start	End
Item	Vegetation			36.995453°	36.995477°
				-120.383334°	-120.373797°
DWR ID	DWR_NA0010_16_s_2024_6				
Comment Code					
V1 : Control annual grass and weeds on the levee slopes and easements.					
Inspector Comment

Looking downstream along the waterside slope. (Spring 2024)

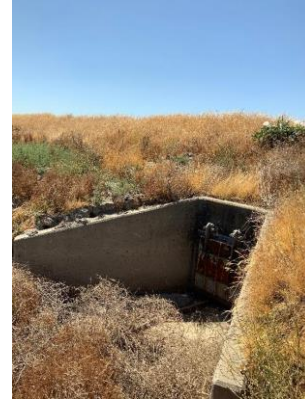
Photo 2 of 2 : UCIP_SP_2024_73370_103849.jpg

WS view: Slope, flapgate, and concrete headwall at toe.

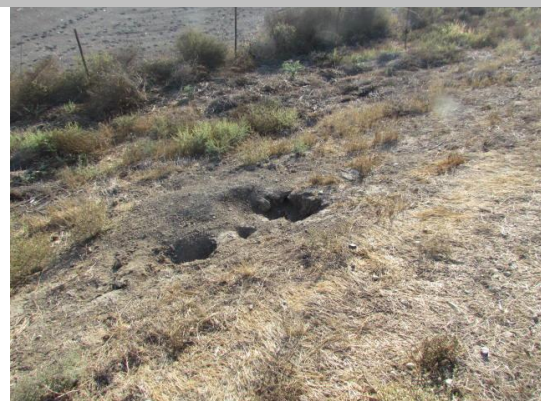
Photo 1 of 1 : SP_2024_NA0010_134_2_20240212_00001.jpg

LM Start	1.77	Rating **	U	Issue No.	2
LM End	1.77	Issue Type +	Ma	Location *	LS
Category	Earthen Levee			GPS Latitude/Longitude	
				Start	End
Item	Animal Control			36.995487°	36.995487°
				-120.377054°	-120.377054°
DWR ID	DWR_NA0010_16_f_2014_2				
Comment Code					
A3 : No rodents visible, but rodent burrows visible; need to backfill and compact or grout burrows.					
Inspector Comment					
Large rodent holes are on the landside slope.

Looking southwest at several rodent holes on landward slope.

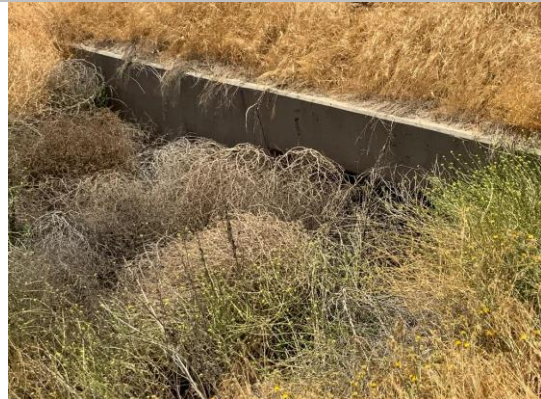
Photo 1 of 1 : UCIP_SP_2024_73434_102398.jpg

Comment Code					
Inspector Comment					
DS_ID:19916 FS_ID:73434 EP_NO: N/A Repair Type: Non-Urgent EVAL Issue: 11, Maintenance Compliance Issue Crossing Status: Found UCIP Comments: 07/13/2021 The record remains Non-Urgent. Limited inspection due to tumbleweeds blocking LS pipe inlet, recommend removal. No permit was found authorizing this encroachment. CVFPB will need to review crossing to determine owner. The UCIP inspection was completed with GEI staff, P. Espinoza. (H. Dunn – GEI) 04/01/2014 Dense vegetation limits the inspector's visibility to identify signs of pipe failure (leaks) along the landward slope. Recommend removing vegetation along pipe alignment to conduct proper inspection of structure. (W. Wylie - DWR UCIP) FIELD_STRUCT_DESC: 48-inch by 60-inch reinforced concrete box gravity drainage culvert (RCBC) through the levee, 14.6 feet below the crown. Flap gate on the waterside (WS) end. Concrete headwall on the landside (LS) end. Concrete U-shaped headwall on the WS end. [Additional Reference(s): DWR Levee Log, 2002, (HLM 2.58). USACE San Joaquin O&M Manual, Unit No. 601, Part No. 1, 1967, Amended in 1978, Revised 20 June 1985, (HLM 2.58). DWR As-Built Specification No. 64-42, Sheet No. 13, 13 August 1964, (HLM 2.58)]. FS Date: 7/19/2021

LS view: Tumbleweeds blocking pipe inlet at toe.

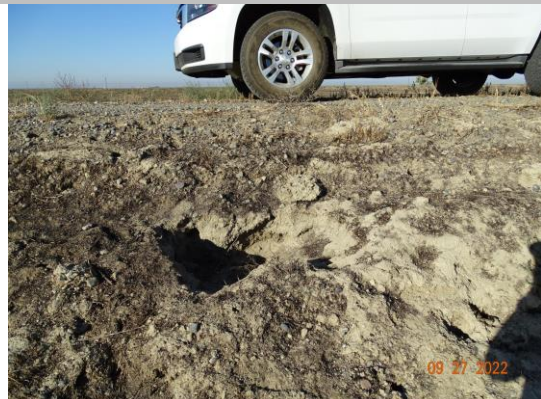
Photo 1 of 1 : SP_2024_NA0010_135_21_20240212_00010.jpg

LM Start	2.88	Rating **	M	Issue No.	21
LM End	2.88	Issue Type +	Ma	Location *	LS
Category	Earthen Levee			GPS Latitude/Longitude	
				Start	End
Item	Animal Control			36.948301°	36.948301°
				-120.346357°	-120.346357°
DWR ID	DWR_NA0010_17_f_2022_21				
Comment Code					
A3 : No rodents visible, but rodent burrows visible; need to backfill and compact or grout burrows.					
Inspector Comment					
Depression in the landside slope appears to be caused by collapsed rodent burrows. Recommend backfilling and compacting.

Representative animal burrow on the landside slope. (Fall 2022)

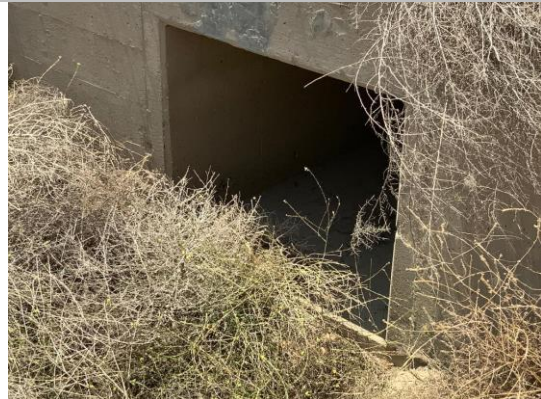
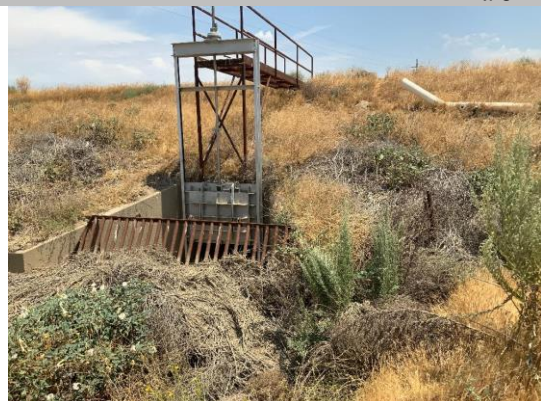
LM Start	4.68	Rating **	M	Issue No.	28 (cont)
LM End	4.68	Issue Type +	En	Location *

DS_ID:19921
 FS_ID:73436
 EP_NO: 13587
 Repair Type: Non-Urgent
 EVAL Issue: 11, Maintenance Compliance Issue
 Crossing Status: Found
 UCIP Comments: 07/13/2021 The record has been upgraded from No Action Needed to Non-Urgent. Dense vegetation over the WS gate, recommend clearing out for better flow during flood season. Some minor vegetation over LS pipe inlet, recommend removal. The UCIP inspection was completed with GEI staff, P. Espinoza. (H. Dunn – GEI)
 FIELD_STRUCT_DESC: 48-inch by 60-inch reinforced concrete box gravity drainage culvert (RCBC) through the levee, 14.6 feet below the crown. Concrete U-shaped headwall on the waterside (WS) end. 36-inch weir on the WS. Combination flap gate and slide gate on the WS toe. Steel walkway to slide gate actuator on the WS shoulder. (3.281-foot-high weir and cable-operated flap valve attached to existing 48-inch by 60-inch RCBC authorized under Permit No. 13587, 1983 - Clark Brothers Farming, Arroyo Ranch). [Additional Reference(s): DWR Levee Log, 2002, (HLM 4.68). USACE San Joaquin O&M Manual, Unit No. 601, Part No. 1, 1967, Amended in 1978, Revised 20 June 1985, (HLM 4.69). DWR As-Built Specification No. 64-42, Sheet No. 14, 13 August 1964, (HLM 4.69)].

LS view: Closeup of pipe inlet at toe.

WS view: Slidegate and slope from toe.

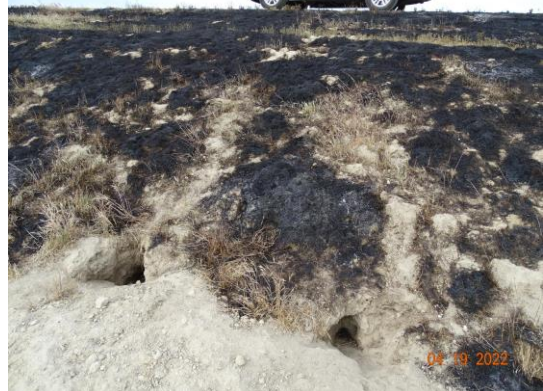
Photo 1 of 1 : SP_2024_NA0010_135_8_20240212_00004.jpg

LM Start	5.75	Rating **	A/W	Issue No.	8
LM End	5.90	Issue Type +	Ma	Location *	LS
Category	Earthen Levee			GPS Latitude/Longitude	
				Start	End
Item	Animal Control			36.908605°	36.906507°
				-120.331112°	-120.330353°
DWR ID	DWR_NA0010_17_s_2012_8				
Comment Code					
A1 : Exterminate rodents and backfill and compact or grout burrows.					
Inspector Comment					
Multiple rodent holes are noted on the landside slope and toe.

Looking at several rodent holes on landside slope. (Spring 2022)

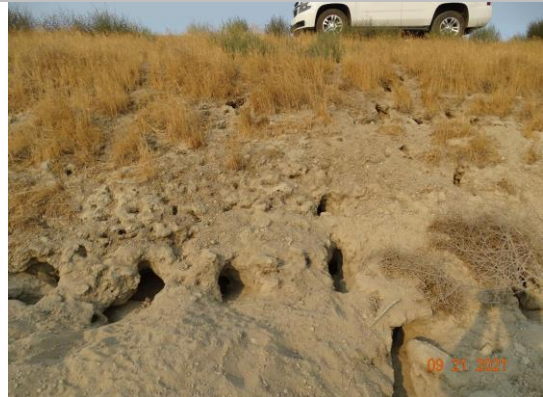
Photo 1 of 1 : SP_2024_NA0010_135_17_20240212_00007.jpg

LM Start	5.92	Rating **	U	Issue No.	17
LM End	5.92	Issue Type +	Ma	Location *	LS
Category	Earthen Levee			GPS Latitude/Longitude	
				Start	End
Item	Animal Control			36.906162°	36.906162°
				-120.330258°	-120.330258°
DWR ID	DWR_NA0010_17_f_2021_17				
Comment Code					
A3 : No rodents visible, but rodent burrows visible; need to backfill and compact or grout burrows.					
Inspector Comment

View of rodent damage to the landside slope. (Fall 2021)

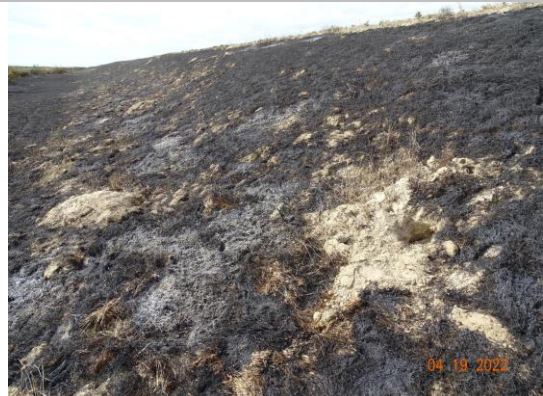
Photo 1 of 1 : SP_2024_NA0010_135_4_20240212_00002.jpg

LM Start	6.60	Rating **	A/W	Issue No.	4
LM End	6.80	Issue Type +	Ma	Location *	LS
Category	Earthen Levee			GPS Latitude/Longitude	
				Start	End
Item	Animal Control			36.896968°	36.894147°
				-120.326126°	-120.324763°
DWR ID	DWR_NA0010_17_s_2012_4				
Comment Code					
A1 : Exterminate rodents and backfill and compact or grout burrows.					
Inspector Comment					
Several rodent holes are identified within this reach.

View of rodent holes on the landside slope. (Spring 2022)

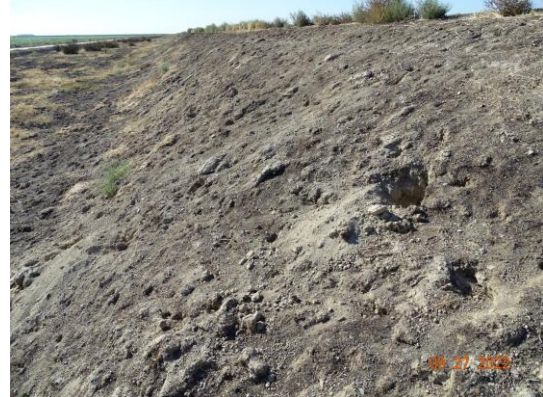
Photo 1 of 1 : SP_2024_NA0010_135_5_20240212_00003.jpg

LM Start	7.27	Rating **	M	Issue No.	5
LM End	7.38	Issue Type +	Ma	Location *	LS
Category	Earthen Levee			GPS Latitude/Longitude	
				Start	End
Item	Animal Control			36.887852°	36.886388°
				-120.321668°	-120.320950°
DWR ID	DWR_NA0010_17_s_2012_5				
Comment Code					
A3 : No rodents visible, but rodent burrows visible; need to backfill and compact or grout burrows.					
Inspector Comment					
Several rodent holes are identified within this reach.

Looking at typical view of rodent holes on landward slope. (Fall 2022)
