Flood Control Project Maintenance
Levee Inspections
LMA District Cover Sheet

Lower San Joaquin Levee District

**Flood Control Project Maintenance
Levee Inspections
Unit Cover Sheet**

Levee Inspection Report By Mile - Spring 2024

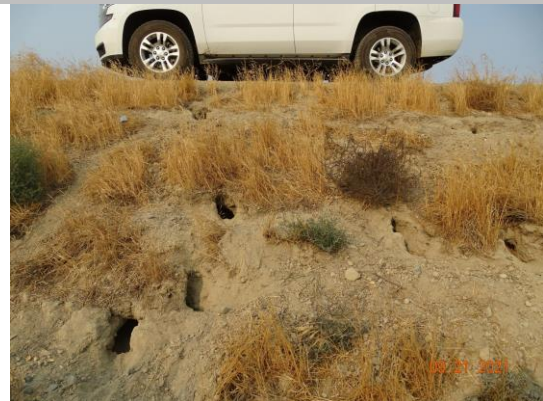
Photo 1 of 1 : SP_2024_NA0010_135_18_20240212_00008.jpg

LM Start	7.74	Rating **	U	Issue No.	18
LM End	7.74	Issue Type +	Ma	Location *	LS
Category	Earthen Levee			GPS Latitude/Longitude	
				Start	End
Item	Animal Control			36.881470°	36.881470°
				-120.318961°	-120.318961°
DWR ID	DWR_NA0010_17_f_2021_18				
Comment Code					
A3 : No rodents visible, but rodent burrows visible; need to backfill and compact or grout burrows.					
Inspector Comment

Looking up the landside slope at several rodent holes. (Fall 2021)

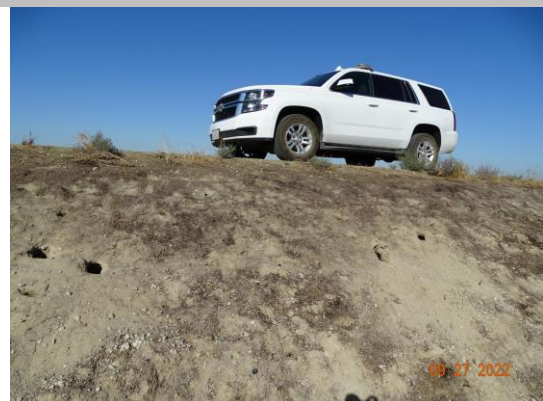
Photo 1 of 1 : SP_2024_NA0010_135_24_20240212_00011.jpg

LM Start	8.15	Rating **	M	Issue No.	24
LM End	8.15	Issue Type +	Ma	Location *	LS
Category	Earthen Levee			GPS Latitude/Longitude	
				Start	End
Item	Animal Control			36.875525°	36.875525°
				-120.317788°	-120.317788°
DWR ID	DWR_NA0010_17_f_2017_24				
Comment Code					
A3 : No rodents visible, but rodent burrows visible; need to backfill and compact or grout burrows.					
Inspector Comment					
Rodent holes are on the landside and crown of levee. Rodent holes have caused some erosion on the landside slope.

Looking east at the landside slope. (Fall 2022)

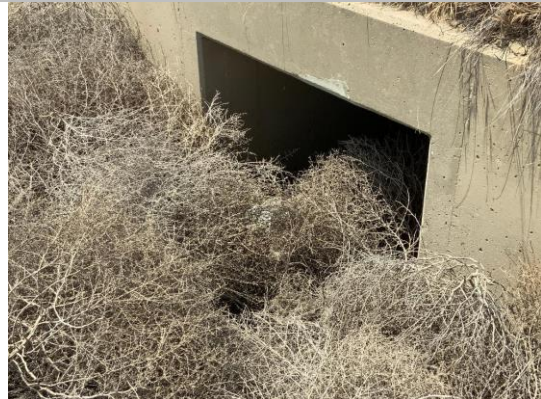
Photo 1 of 1 : UCIP_SP_2024_73439_102427.jpg

Comment Code						
Inspector Comment						
DS_ID:19917 FS_ID:73439 EP_NO: N/A Repair Type: Non-Urgent EVAL Issue: 11, Maintenance Compliance Issue Crossing Status: Found UCIP Comments: 07/13/2021 The record remains Non-Urgent. Limited inspection due to dense tumbleweeds over LS pipe inlet, recommend removal. No permit was found authorizing this encroachment. CVFPB will need to review crossing to determine owner. The UCIP inspection was completed with GEI staff, P. Espinoza. (H. Dunn – GEI) 04/01/2014 Dense vegetation limits the inspector's visibility to identify signs of pipe failure (leaks) along the landward slope. Recommend removing vegetation along pipe alignment to conduct proper inspection of structure. (W. Wylie - DWR UCIP) FIELD_STRUCT_DESC: 48-inch by 60-inch reinforced concrete box gravity drainage culvert (RCBC) through the levee, 15.0 feet below the crown. Concrete headwall on the landside (LS) end. Concrete U-shaped headwall on the waterside (WS) end. [Additional Reference(s): DWR Levee Log, 2002, (HLM 9.89). USACE San Joaquin O&M Manual, Unit No. 601, Part No. 1, 1967, Amended in 1978, Revised 20 June 1985, (HLM 9.89). DWR As-Built Specification No. 64-42, Sheet No. 18, 13 August 1964, (HLM 9.89)]. FS Date: 7/19/2021

LS view: Closeup of inlet at toe covered by tumbleweeds.

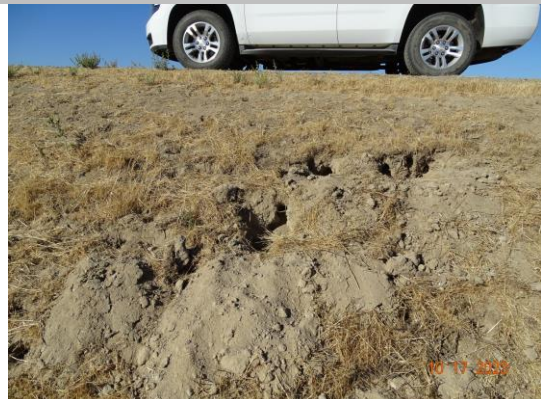
Photo 1 of 1 : SP_2024_NA0010_135_15_20240212_00005.jpg

LM Start	9.92	Rating **	M	Issue No.	15
LM End	9.92	Issue Type +	Ma	Location *	LS
Category	Earthen Levee			GPS Latitude/Longitude	
				Start	End
Item	Animal Control			36.850063 °	36.850063 °
				-120.314122 °	-120.314122 °
DWR ID	DWR_NA0010_17_f_2023_15				
Comment Code					
A3 : No rodents visible, but rodent burrows visible; need to backfill and compact or grout burrows.					
Inspector Comment

Multiple rodent holes observed in the landside slope. (Fall 2023)

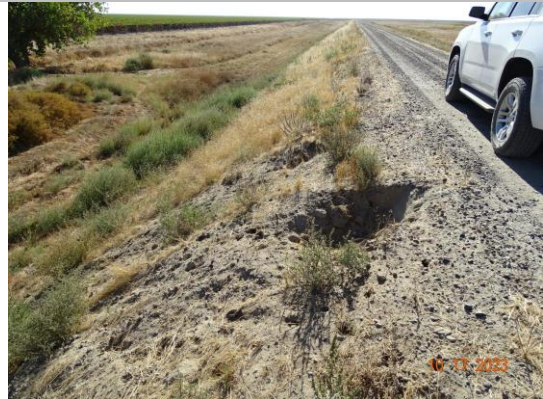
Photo 1 of 1 : SP_2024_NA0010_135_16_20240212_00006.jpg

LM Start	11.10	Rating **	M	Issue No.	16
LM End	11.10	Issue Type +	Ma	Location *	LS
Category	Earthen Levee			GPS Latitude/Longitude	
				Start	End
Item	Erosion / Vehicle Traffic			36.836100°	36.836100°
				-120.304535°	-120.304535°
DWR ID	DWR_NA0010_17_s_2024_16				
Comment Code					
E6 : Repair the levee slope damaged by vehicle traffic and prevent access where possible.					
Inspector Comment

Vehicle damage to the landside slope and shoulder. (Fall 2023)

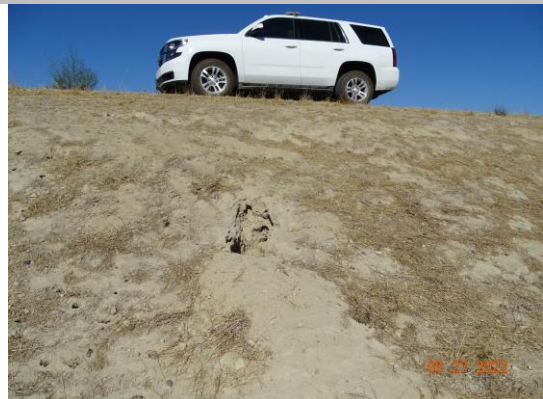
Photo 1 of 1 : SP_2024_NA0010_135_26_20240212_00012.jpg

LM Start	12.10	Rating **	U	Issue No.	26
LM End	12.10	Issue Type +	Ma	Location *	LS
Category	Earthen Levee			GPS Latitude/Longitude	
				Start	End
Item	Animal Control			36.823794°	36.823794°
				-120.299278°	-120.299278°
DWR ID	DWR_NA0010_17_f_2022_26				
Comment Code					
A3 : No rodents visible, but rodent burrows visible; need to backfill and compact or grout burrows.					
Inspector Comment

Large animal burrow in the landside slope. (Fall 2022)

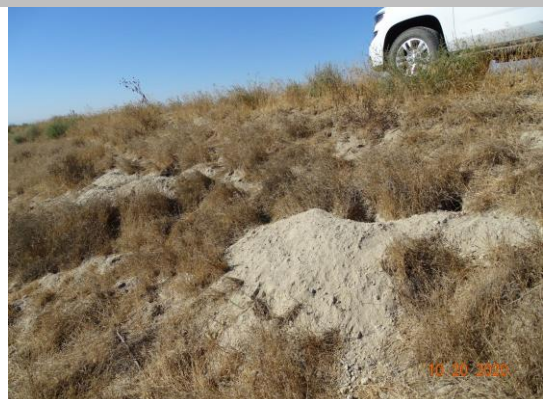
Photo 1 of 1 : SP_2024_NA0010_135_19_20240212_00009.jpg

LM Start	12.25	Rating **	U	Issue No.	19
LM End	12.25	Issue Type +	Ma	Location *	LS
Category	Earthen Levee			GPS Latitude/Longitude	
				Start	End
Item	Animal Control			36.821776°	36.821776°
				-120.300137°	-120.300137°
DWR ID	DWR_NA0010_17_f_2022_19				
Comment Code					
A3 : No rodents visible, but rodent burrows visible; need to backfill and compact or grout burrows.					
Inspector Comment

View of rodent burrows on the landside slope. (Fall 2020)

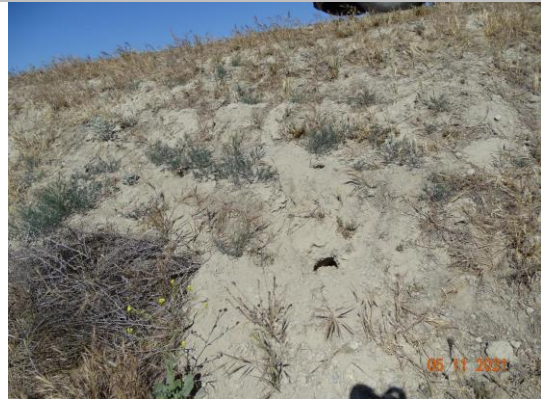
Photo 1 of 1 : SP_2024_NA0010_135_3_20240212_00001.jpg

LM Start	12.28	Rating **	M	Issue No.	3
LM End	12.32	Issue Type +	Ma	Location *	LS
Category	Earthen Levee			GPS Latitude/Longitude	
				Start	End
Item	Animal Control			36.821368 °	36.820843 °
				-120.300283 °	-120.300469 °
DWR ID	DWR_NA0010_17_s_ 2014_3				
Comment Code					
A3 : No rodents visible, but rodent burrows visible; need to backfill and compact or grout burrows.					
Inspector Comment

View of multiple rodent holes in the landside slope. (Spring 2021)

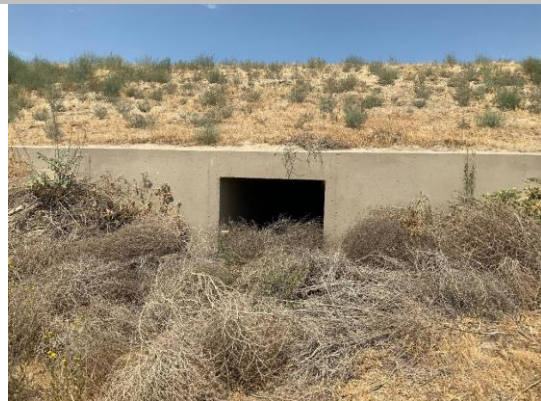
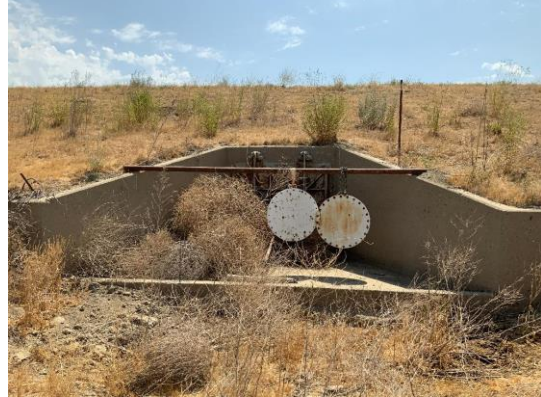
LM Start	13.29	Rating **	M	Issue No.	31	
LM End	13.29	Issue Type +	Ma	Location *		
Category	Supplemental			GPS Latitude/Longitude		
				Start		End
Item	DWR UCIP LMA Responsibility			36.807509 °		36.807509 °
				-120.306231 °		-120.306231 °
DWR ID	19918

Comment Code						
Inspector Comment						
DS_ID:19918 FS_ID:73440 EP_NO: N/A Repair Type: Non-Urgent EVAL Issue: 11, Maintenance Compliance Issue Crossing Status: Found UCIP Comments: 07/13/2021 The record remains Non-Urgent. WS flapgate has plank holding it shut, remove before flood season. Limited inspection due to dense tumbleweeds covering LS pipe inlet, recommend removal. No permit was found authorizing this encroachment. CVFPB will need to review crossing to determine owner. The UCIP inspection was completed with GEI staff, P. Espinoza. (H. Dunn – GEI) 04/01/2014 Some vegetation buildup at inlet– recommend clearing. (W. Wylie - DWR UCIP) FIELD_STRUCT_DESC: 48-inch by 60-inch reinforced concrete box gravity drainage culvert (RCBC) through the levee, 15.3 feet below the crown. Flap gate on the waterside (WS) end. Concrete headwall on the landside (LS) end. Concrete U-shaped headwall on the WS end. [Additional Reference(s): DWR Levee Log, 2002, (HLM 13.29). USACE San Joaquin O&M Manual, Unit No. 601, Part No. 1, 1967, Amended in 1978, Revised 20 June 1985, (HLM 13.30). DWR As-Built Specification No. 64-42, Sheet No. 21, 13 August 1964, (HLM 13.30)]. FS Date: 7/19/2021

LS view: Headwall and slope from toe.

WS view: Headwall, flapgate, and slope from toe.

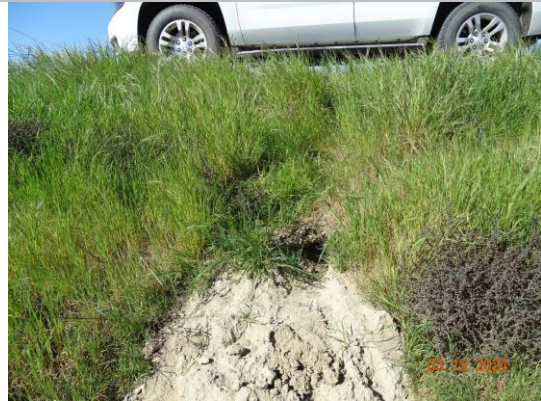
Photo 1 of 1 : SP_2024_NA0010_135_12_20240327_00023.jpg

LM Start	13.64	Rating **	M	Issue No.	12
LM End	13.64	Issue Type +	Ma	Location *	LS
Category	Earthen Levee			GPS Latitude/Longitude	
				Start	End
Item	Animal Control			36.802650 °	36.802650 °
				-120.306999 °	-120.306999 °
DWR ID	DWR_NA0010_17_s_2024_12				
Comment Code					
A3 : No rodents visible, but rodent burrows visible; need to backfill and compact or grout burrows.					
Inspector Comment

Representative view of rodent holes on the landside slope. (Spring 2024)

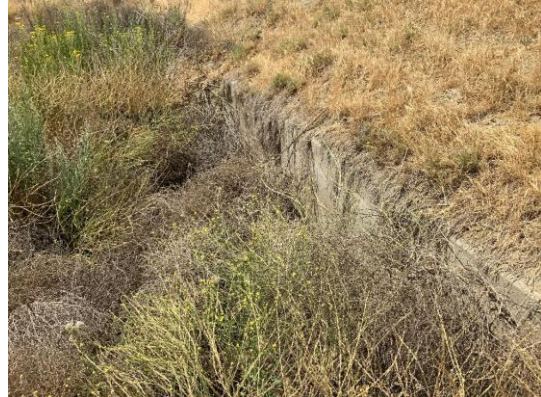
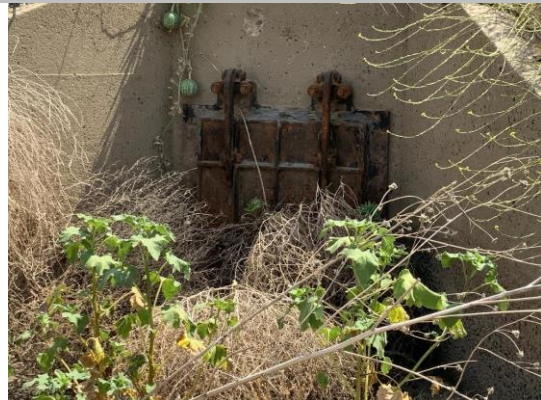
LM Start	14.69	Rating **	U	Issue No.	32 (cont)
LM End	14.69	Issue Type +	Ma	Location *

Comment Code						
Inspector Comment						
DS_ID:19920 FS_ID:77872 EP_NO: N/A Repair Type: Urgent EVAL Issue: 1, Pipe Integrity Crossing Status: Found UCIP Comments: 12/14/2022 Record updated from Non-Urgent to Urgent. DMP internal video inspection has found pipe integrity issues. LOF of crossing is between 5 and 6. Crossing will be monitored until funding becomes available to address the issues. (O.Yakimov - DWR UCIP) 07/19/2021 The record remains Non-Urgent. Dense tumbleweeds over WS flapgate and LS inlet, recommend removal of both sides. Limited inspection on both WS and LS ends. No permit was found authorizing this encroachment. CVFPB will need to review crossing to determine owner. The UCIP inspection was completed with GEI staff, P. Espinoza. (H. Dunn – GEI) 04/01/2014 Heavy vegetation buildup at LS toe-- recommend clearing. (W. Wylie - DWR UCIP) FIELD_STRUCT_DESC: 30-inch by 30-inch square reinforced concrete box gravity drainage culvert (RCBC) through the levee, 14.0 feet below the crown. Flap gate on the waterside (WS) end. Concrete headwall on the landside (LS) end. Concrete U-shaped headwall on the WS end. [Additional Reference(s): DWR Levee Log, 2002, (HLM 14.70). USACE San Joaquin O&M Manual, Unit No. 601, Part No. 1, 1967, Amended in 1978, Revised 20 June 1985, (HLM 14.69). DWR As-Built Specification No. 64-42, Sheet No. 22, 13 August 1964, (HLM 14.69)]. FS Date: 7/19/2021 2:07:23 PM

LS view: Headwall barely visible at toe due to dense vegetation.

WS view: Closeup of flapgate at toe.

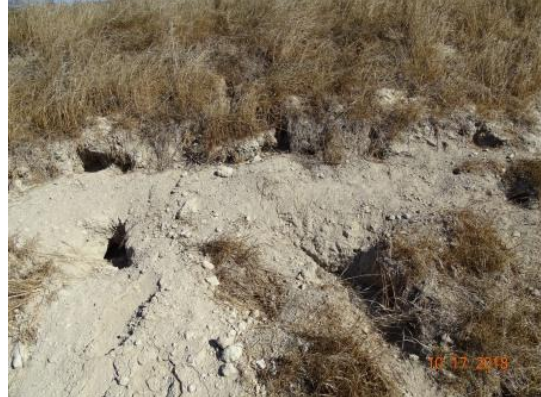
Photo 1 of 1 : SP_2024_NA0010_137_55_20240212_00014.jpg

LM Start	0.78	Rating **	M	Issue No.	55
LM End	0.78	Issue Type +	Ma	Location *	LS
Category	Earthen Levee			GPS Latitude/Longitude	
				Start	End
Item	Animal Control			36.964824°	36.964824°
				-120.358065°	-120.358065°
DWR ID	DWR_NA0010_18_f_2018_55				
Comment Code					
A3 : No rodents visible, but rodent burrows visible; need to backfill and compact or grout burrows.					
Inspector Comment

View of rodent holes from levee toe looking towards centerline. (Fall 2018)

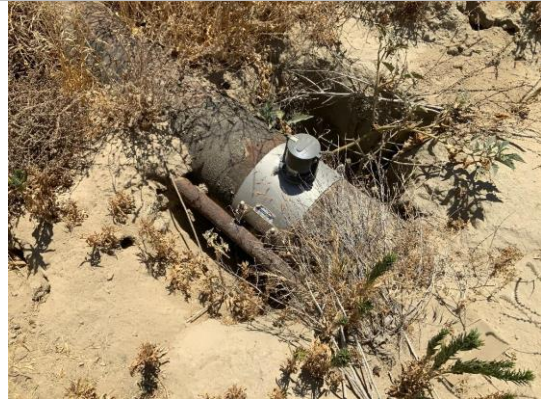
Photo 1 of 1 : UCIP_SP_2024_73459_102065.jpg

DS_ID:19925
FS_ID:73459
EP_NO: 6603
Repair Type: Non-Urgent
EVAL Issue: 6, Levee Damage or Threat for Levee Damage
Crossing Status: Found
UCIP Comments: 07/20/2021 The record remains Non-Urgent.
Flowmeter and pump on pipe appears newer, likely not abandoned as stated in previous inspection. Some erosion around the flowmeter on WS slope. The UCIP inspection was completed with GEI staff, P. Espinoza. (H. Dunn – GEI) 04/10/2014 Need to contact owner. Appears abandoned--good candidate for video or pressure inspection. This crossings is the same age as the pipe that has failed immediately upstream. (DWR UCIP - O. Magana)
FIELD_STRUCT_DESC: 15-inch steel irrigation discharge pipe through the levee, 4.3 feet below the crown. Electrical conduit of an unknown size or material through the levee, 4.3 feet below the crown. Siphon breaker on the landside (LS) shoulder. 36-inch concrete standpipe on the LS berm. Inlet facility on the waterside (WS) bank, consisting of a pump, a 42-inch concrete standpipe, and a 20-inch concrete channel with an intake pipe and a cutoff wall. (Outlet pipe and pump authorized under Permit No. 6603, 1969 - Raymond N. Costales). [Additional Reference(s): DWR Levee Log, 2002, (HLM 1.69)].

WS view: Some erosion around the flowmeter on slope.

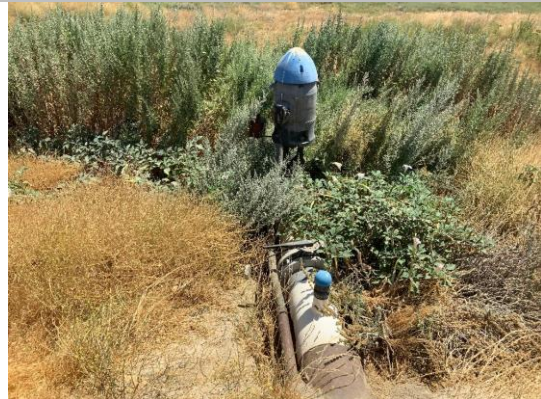
Photo 1 of 1 : UCIP_SP_2024_73463_102080.jpg

Comment Code					
Inspector Comment					
DS_ID:19926 FS_ID:73463 EP_NO: 6603 Repair Type: Non-Urgent EVAL Issue: 11, Maintenance Compliance Issue Crossing Status: Found UCIP Comments: 07/20/2021 The record remains Non-Urgent. WS has some vegetation growth around the pump and pipe on the slope, recommend removal. No LS standpipe or siphon breaker visible and new filtration system set up landward off the LS toe. Unsure if pipe connected to filtration system and penetrating the ground on LS belongs to this crossing. Confirm with owner on the status of this pipe and the alignment. The UCIP inspection was completed with GEI staff, P. Espinoza. (H. Dunn – GEI) 7/20/2016 High burrow activity. Dense vegetation limits the inspector's visibility to identify signs of pipe failure (leaks) along the WS and LS slope. Recommend removing vegetation along pipe alignment to conduct proper inspection of structure and appurtenances. (DWR UCIP - omagana)4/10/2014 Subsidence present along pipe alignment on landward side. Modified crossing--worked done on landward side. Need to contact owner to determine permit authorizing work. Dense vegetation on landward side--tall grass. Pipe wall cut and new pipe sleeved on landward side. (DWR UCIP - omagana) FIELD_STRUCT_DESC: 15-inch steel irrigation discharge pipe and electrical conduit through the levee, 3.7 feet below the crown. Siphon breaker on the landside (LS) shoulder. 36-inch concrete standpipe on the LS berm. Inlet facility on the riverbank, consisting of a pump, a 42-inch concrete standpipe, and a 20-inch concrete channel with an intake pipe and a cutoff wall. (Outlet pipe and pump authorized under Permit No. 6603, 1969 - Raymond N. Costales). [Additional Reference(s): DWR Levee Log, 2002, (HLM 2.25)]. FS Date: 7/20/2021

WS view: Pump and pipe off slope, covered with vegetation.

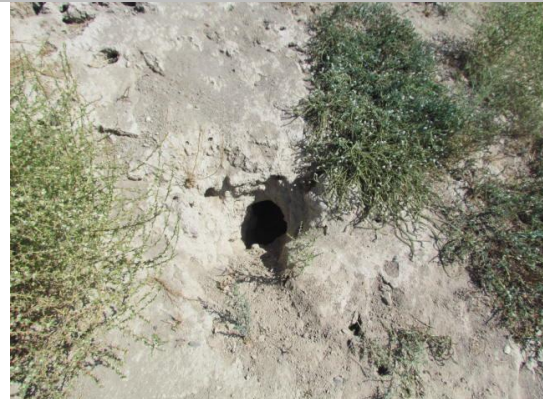
LS view: Headwall visible on LS toe

LM Start	2.25	Rating **	A/W	Issue No.	8
LM End	2.25	Issue Type +	Ma	Location *	LS
Category	Earthen Levee			GPS Latitude/Longitude	
				Start	End
Item	Animal Control			36.945563°	36.945563°
				-120.347121°	-120.347121°
DWR ID	DWR_NA0010_18_f_2015_8				
Comment Code					
A3 : No rodents visible, but rodent burrows visible; need to backfill and compact or grout burrows.					
Inspector Comment					
There is one large rodent hole and other smaller rodent holes within this area.

Looking at large rodent hole on landward slope.

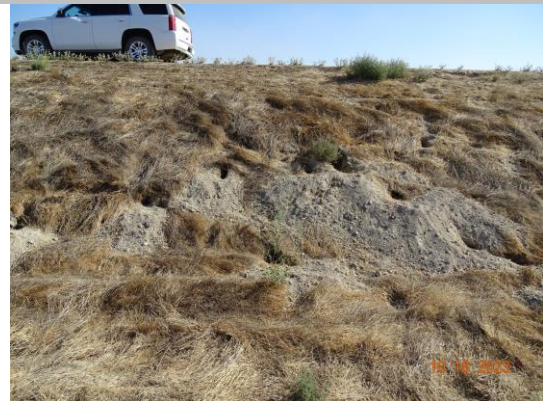
Photo 1 of 1 : SP_2024_NA0010_137_32_20240212_00009.jpg

LM Start	3.34	Rating **	M	Issue No.	32
LM End	3.34	Issue Type +	Ma	Location *	LS
Category	Earthen Levee			GPS Latitude/Longitude	
				Start	End
Item	Animal Control			36.930419°	36.930419°
				-120.341433°	-120.341433°
DWR ID	DWR_NA0010_18_f_2023_32				
Comment Code					
A3 : No rodents visible, but rodent burrows visible; need to backfill and compact or grout burrows.					
Inspector Comment

View of rodent holes on the landside slope. (Fall 2023)

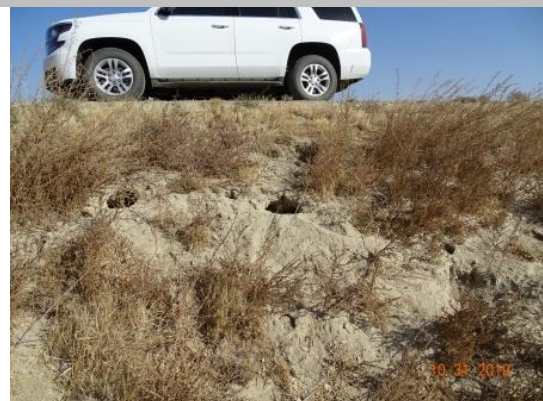
Photo 1 of 1 : SP_2024_NA0010_137_31_20240212_00008.jpg

LM Start	3.41	Rating **	U	Issue No.	31
LM End	3.44	Issue Type +	Ma	Location *	LS
Category	Earthen Levee			GPS Latitude/Longitude	
				Start	End
Item	Animal Control			36.929498°	36.929093°
				-120.341091°	-120.340920°
DWR ID	DWR_NA0010_18_f_2019_31				
Comment Code					
A3 : No rodents visible, but rodent burrows visible; need to backfill and compact or grout burrows.					
Inspector Comment

View of rodent burrows in the landside slope. (Fall 2019)

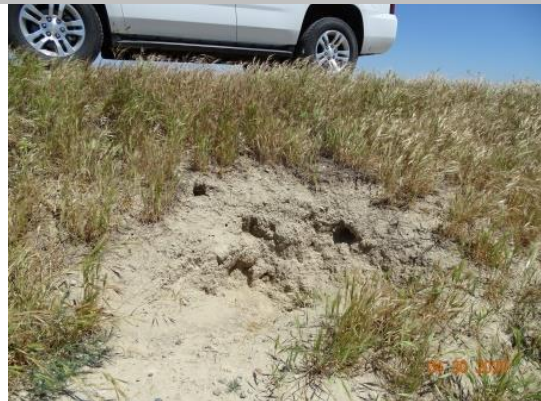
Photo 1 of 1 : SP_2024_NA0010_137_47_20240212_00013.jpg

LM Start	3.73	Rating **	U	Issue No.	47
LM End	3.73	Issue Type +	Ma	Location *	LS
Category	Earthen Levee			GPS Latitude/Longitude	
				Start	End
Item	Animal Control			36.924969°	36.924969°
				-120.339407°	-120.339407°
DWR ID	DWR_NA0010_18_s_2020_47				
Comment Code					
A3 : No rodents visible, but rodent burrows visible; need to backfill and compact or grout burrows.					
Inspector Comment

Large rodent burrow in the landside slope. (Spring 2020)

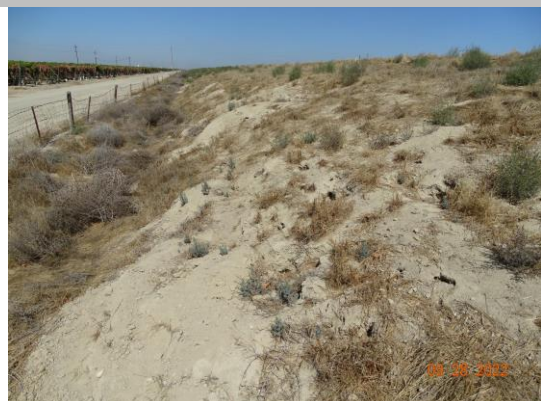
Photo 1 of 1 : SP_2024_NA0010_137_44_20240212_00012.jpg

LM Start	3.93	Rating **	U	Issue No.	44
LM End	3.98	Issue Type +	Ma	Location *	LS
Category	Earthen Levee			GPS Latitude/Longitude	
				Start	End
Item	Animal Control			36.922195°	36.921549°
				-120.338412°	-120.338173°
DWR ID	DWR_NA0010_18_f_2022_44				
Comment Code					
A3 : No rodents visible, but rodent burrows visible; need to backfill and compact or grout burrows.					
Inspector Comment					
Several rodent burrows observed in the landside slope and berm.

Several rodent holes noted in this section. (Fall 2022)

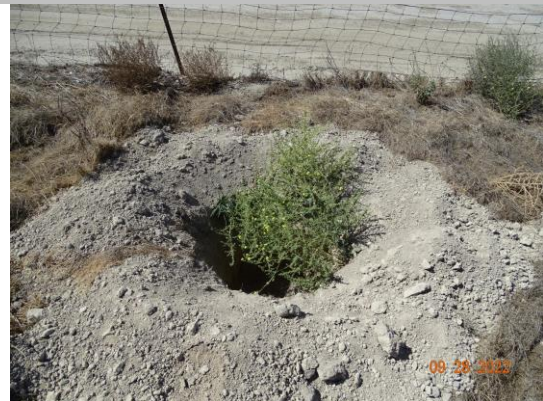
Photo 1 of 1 : SP_2024_NA0010_137_43_20240212_00011.jpg

LM Start	4.58	Rating **	U	Issue No.	43
LM End	4.58	Issue Type +	Ma	Location *	LS
Category	Earthen Levee			GPS Latitude/Longitude	
				Start	End
Item	Animal Control			36.913142°	36.913142°
				-120.335093°	-120.335093°
DWR ID	DWR_NA0010_18_f_2022_43				
Comment Code					
A3 : No rodents visible, but rodent burrows visible; need to backfill and compact or grout burrows.					
Inspector Comment					
Large hole at the landside toe of the levee.

Large animal hole on the landside toe. (Fall 2022)

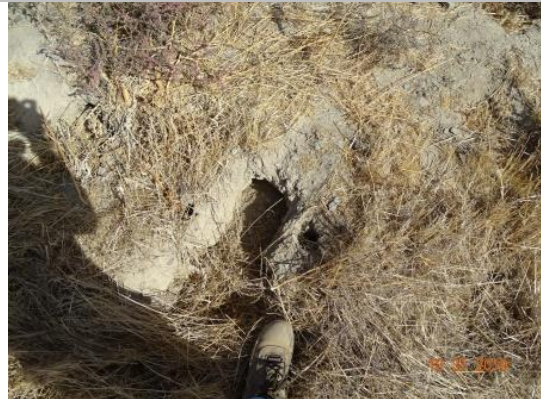
Photo 1 of 1 : SP_2024_NA0010_137_23_20240212_00007.jpg

LM Start	6.84	Rating **	U	Issue No.	23
LM End	6.84	Issue Type +	Ma	Location *	LS
Category	Earthen Levee			GPS Latitude/Longitude	
				Start	End
Item	Animal Control			36.882384°	36.882384°
				-120.321417°	-120.321417°
DWR ID	DWR_NA0010_18_f_2019_23				
Comment Code					
A1 : Exterminate rodents and backfill and compact or grout burrows.					
Inspector Comment

Representative view of rodent burrows observed at this location. (Fall 2019)

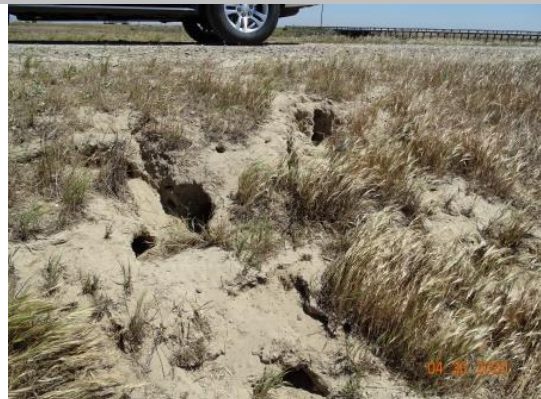
Photo 1 of 1 : SP_2024_NA0010_137_14_20240212_00003.jpg

LM Start	7.39	Rating **	U	Issue No.	14
LM End	7.53	Issue Type +	Ma	Location *	LS
Category	Earthen Levee			GPS Latitude/Longitude	
				Start	End
Item	Animal Control			36.874479°	36.872503°
				-120.319831°	-120.319438°
DWR ID	DWR_NA0010_18_f_2017_14				
Comment Code					
A3 : No rodents visible, but rodent burrows visible; need to backfill and compact or grout burrows.					
Inspector Comment					
There are several rodent holes noted along the landside slope in this area.

View of rodent burrows in the landside slope. (Spring 2020)

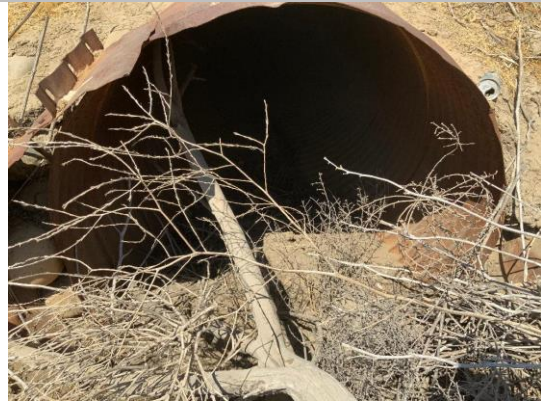
Photo 1 of 1 : UCIP_SP_2024_73468_102096.jpg

Comment Code					
Inspector Comment					
DS_ID:19930 FS_ID:73468 EP_NO: 13548 Repair Type: Non-Urgent EVAL Issue: 11, Maintenance Compliance Issue Crossing Status: Found UCIP Comments: 07/20/2021 The record remains Non-Urgent. No longer debris or sediment inside LS pipe outlet. WS pipe does not appear to be distorted, but has minor vegetation over inlet, recommend removal. The UCIP inspection was completed with GEI staff, P. Espinoza. (H. Dunn – GEI) 04/10/2014 CMP crossing is distorted on waterward side. Debris scattered on landward side. Sediment deposit inside crossing visible from landward side. Recommend removing debris from landward side. (DWR UCIP - O. Magana) FIELD_STRUCT_DESC: 42-inch reinforced concrete (RC) gravity irrigation pipe through the levee, 19.0 feet below the crown. Gate structure on the waterside (WS) shoulder. Pipe section on the WS is made of corrugated metal (CM). Pipe section on the landside (LS) is made of RC. (42-inch RC gravity irrigation pipe authorized under Permit No. 13548, 1983 - New Stone Water District). [Additional Reference(s): DWR Levee Log, 2002, (HLM 7.53)]. FS Date: 7/30/2021 3:01:27 PM

WS view: Closeup of pipe inlet at toe.

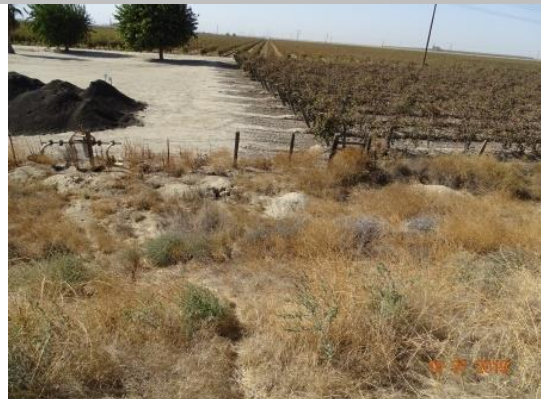
Photo 1 of 1 : SP_2024_NA0010_137_21_20240212_00006.jpg

LM Start	7.91	Rating **	U	Issue No.	21
LM End	7.98	Issue Type +	Ma	Location *	LS
Category	Earthen Levee			GPS Latitude/Longitude	
				Start	End
Item	Animal Control			36.867030°	36.866092°
				-120.318361°	-120.318180°
DWR ID	DWR_NA0010_18_f_2019_21				
Comment Code					
A3 : No rodents visible, but rodent burrows visible; need to backfill and compact or grout burrows.					
Inspector Comment					
Several large rodent burrows in the landside toe.

Several rodent burrows observed at the landside toe. (Fall 2019)

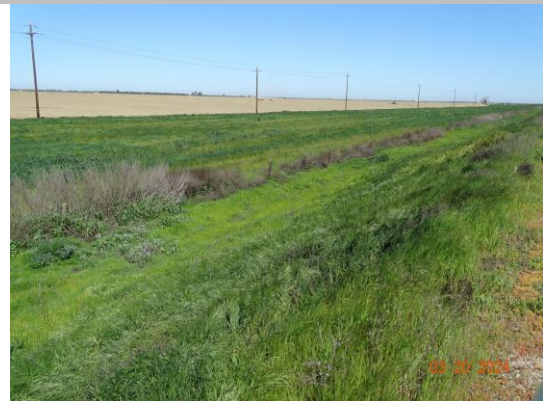
Photo 1 of 1 : SP_2024_NA0010_137_10_20240327_00019.jpg

LM Start	8.31	Rating **	M	Issue No.	10
LM End	8.97	Issue Type +	Ma	Location *	LS
Category	Earthen Levee			GPS Latitude/Longitude	
				Start	End
Item	Vegetation			36.861354°	36.851803°
				-120.317290°	-120.316433°
DWR ID	DWR_NA0010_18_s_2024_10				
Comment Code					
V1 : Control annual grass and weeds on the levee slopes and easements.					
Inspector Comment

View of vegetation on the landside slope. (Spring 2024)

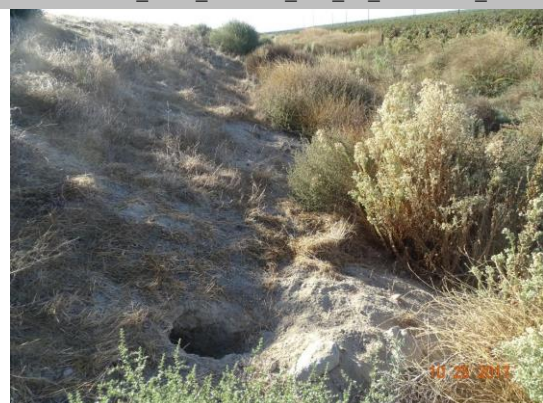
Photo 1 of 1 : SP_2024_NA0010_137_13_20240212_00002.jpg

LM Start	8.67	Rating **	U	Issue No.	13
LM End	8.67	Issue Type +	Ma	Location *	LS
Category	Earthen Levee			GPS Latitude/Longitude	
				Start	End
Item	Animal Control			36.856115°	36.856115°
				-120.316595°	-120.316595°
DWR ID	DWR_NA0010_18_f_2017_13				
Comment Code					
A3 : No rodents visible, but rodent burrows visible; need to backfill and compact or grout burrows.					
Inspector Comment

Looking south at the landside slope.

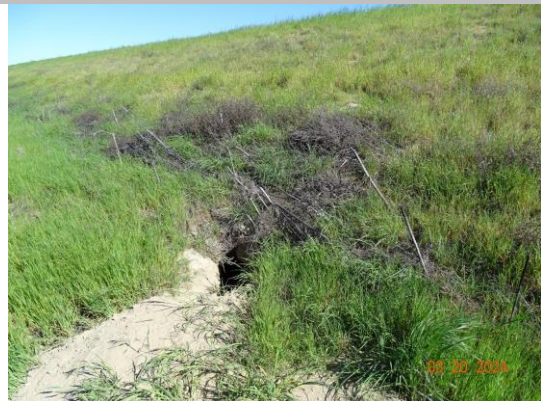
Photo 1 of 1 : SP_2024_NA0010_137_7_20240327_00020.jpg

LM Start	10.49	Rating **	M	Issue No.	7
LM End	10.49	Issue Type +	Ma	Location *	LS
Category	Earthen Levee			GPS Latitude/Longitude	
				Start	End
Item	Animal Control			36.833491°	36.833491°
				-120.304470°	-120.304470°
DWR ID	DWR_NA0010_18_s_2024_7				
Comment Code					
A3 : No rodents visible, but rodent burrows visible; need to backfill and compact or grout burrows.					
Inspector Comment					
Large burrow observed at the landside toe.

Large rodent hole observed at the landside toe. (Spring 2024)

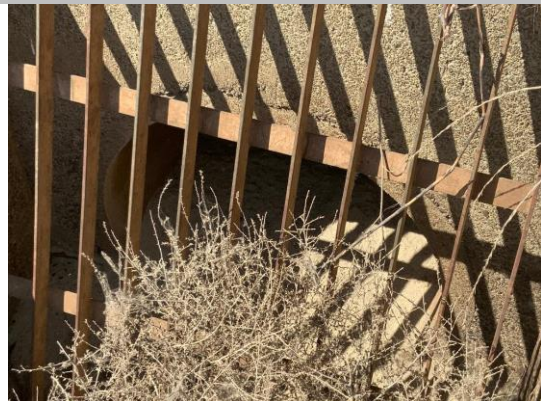
Photo 1 of 1 : UCIP_SP_2024_73470_102110.jpg

Comment Code						
Inspector Comment						
DS_ID:19569 FS_ID:73470 EP_NO: 13049 Repair Type: Non-Urgent EVAL Issue: 11, Maintenance Compliance Issue Crossing Status: Found UCIP Comments: 07/20/2021 The record has been upgraded from No Action Needed to Non-Urgent. LS pipe inlet is across the road and behind barbed wire, could not access, limited inspection. WS pipe outlet has sediment buildup inside, recommend removal. The UCIP inspection was completed with GEI staff, P. Espinoza. (H. Dunn – GEI) FIELD_STRUCT_DESC: 36-inch reinforced concrete (RC) gravity drainage pipe through the levee, 14.8 feet below the crown. Gate structure on the waterside (WS) slope. Standpipe on the WS end. Riprap on the landside (LS) slope. (36-inch RC gravity drainage pipe authorized under Permit No. 13049, 1981 - Newhall Land and Farming Company). [Additional Reference(s): DWR Levee Log, 2002, (HLM 13.37)]. FS Date: 7/20/2021

WS view: Closeup of pipe inlet at toe with sediment buildup.

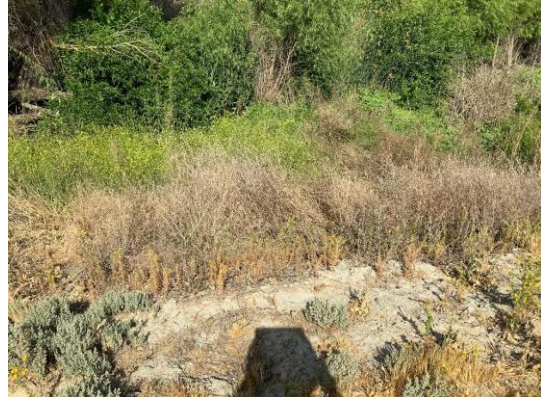
Photo 1 of 2 : UCIP_SP_2024_73507_103856.jpg

Comment Code						
Inspector Comment						
DS_ID:19933 FS_ID:73507 EP_NO: N/A Repair Type: Non-Urgent EVAL Issue: 4b, Safety Issue Crossing Status: Found UCIP Comments: 06/09/2021 The record remains Non-Urgent. Limited inspection of LS due to dense vegetation; recommend removal. Limited inspection on WS due to elevated water level. No pipe inlet or outlet was visible on LS or WS. Riser on WS missing lid, causing a safety hazard. No permit was found authorizing this encroachment. CVFPB will need to review crossing to determine owner. The UCIP inspection was completed with GEI staff, H.Dunn. (P.Espinoza – GEI) 07/19/2016 Gate inside riser appears operable--riser lid damage. Crossing is not visible on LS due to dense vegetation. Recommend clearing dense vegetation along WS and LS slope and repairing riser cover. (O. Magana - DWR UCIP)04/15/2014 No actuator wheel on slide gate at WS shoulder. (W. Wylie - DWR UCIP) FIELD_STRUCT_DESC: 24-inch corrugated metal gravity drainage pipe (CMP) through the levee, 14.8 feet below the crown. Slide gate in a 36-inch CMP riser unit on the waterside (WS) slope. Concrete U-shaped headwall on each end. [Additional Reference(s): DWR Levee Log, 2002, (HLM 0.10). USACE San Joaquin O&M Manual, Unit No. 601, Part No. 1, 1967, Amended in 1978, Revised 20 June 1985, (HLM 0.10). DWR As-Built Specification No. 63-25, Sheet No. 15, 9 May 1963, (HLM 0.10)]. FS Date: 6/9/2021 12:38:00 PM

LS view: Toe from crown, dense vegetation.

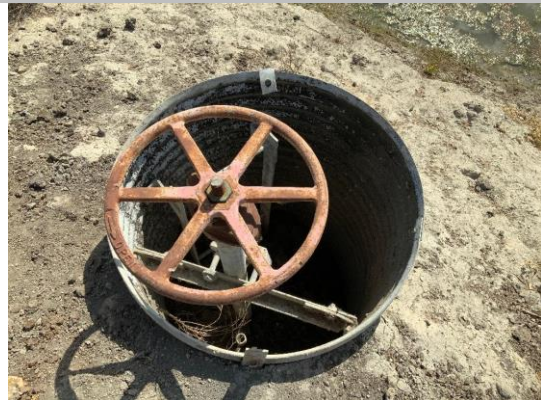
Photo 2 of 2 : UCIP_SP_2024_73507_103855.jpg

WS view: close up of CMP riser on slope.

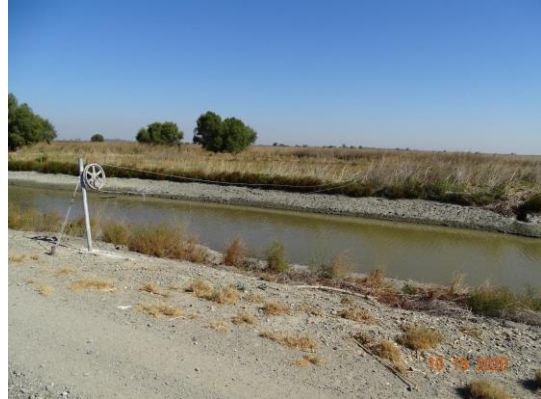
Photo 1 of 1 : SP_2024_NA0010_138_23_20240212_00013.jpg

LM Start	0.87	Rating **	M	Issue No.	23
LM End	0.87	Issue Type +	En	Location *	WS
Category	Earthen Levee			GPS Latitude/Longitude	
				Start	End
Item	Encroachments			37.217802°	37.217802°
				-120.697416°	-120.697416°
DWR ID	DWR_NA0010_22A_f_2014_23				
Comment Code					
SI : Sign					
Inspector Comment					
A pulley is located on the waterside shoulder without a board permit.

Pulley on the waterside shoulder. (Fall 2020)

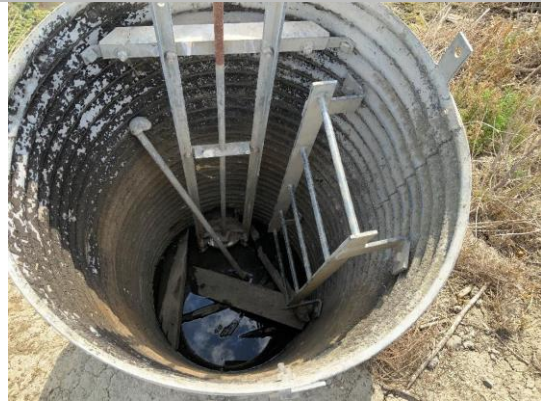
Photo 2 of 2 : UCIP_SP_2024_77873_103903.jpg

LM Start	1.57	Rating **	U	Issue No.	39 (cont)
LM End	1.57	Issue Type +	En	Location *	
Category	Supplemental			GPS Latitude/Longitude	
				Start	End
Item	DWR UCIP Field Study			37.227588°	37.227588°
				-120.700945°	-120.700945°
DWR ID	19936

WS view: closeup of interior of (CMP) riser.

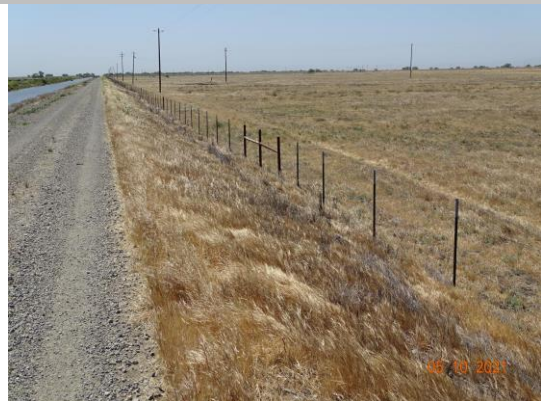
Photo 1 of 1 : SP_2024_NA0010_138_28_20240212_00015.jpg

LM Start	1.75	Rating **	A/W	Issue No.	28
LM End	2.60	Issue Type +	En	Location *	LS
Category	Earthen Levee			GPS Latitude/Longitude	
				Start	End
Item	Encroachments			37.230585°	37.242371°
				-120.702045°	-120.706371°
DWR ID	DWR_NA0010_22A_f_2018_28				
Comment Code					
FE : Fence					
Inspector Comment					
A fence is located along the landside toe. This is shown in the as-built drawings.

View of fence along landside toe. (Spring 2021)

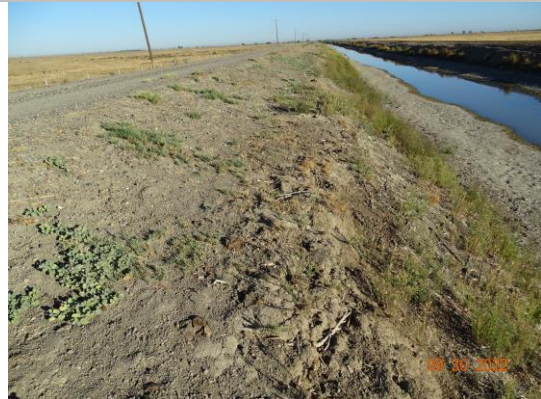
Photo 1 of 1 : SP_2024_NA0010_138_29_20240212_00016.jpg

LM Start	2.25	Rating **	M	Issue No.	29
LM End	2.37	Issue Type +	Ma	Location *	WS
Category	Earthen Levee			GPS Latitude/Longitude	
				Start	End
Item	Erosion / Livestock			37.237050°	37.238776°
				-120.704393°	-120.705028°
DWR ID	DWR_NA0010_22A_f_2018_29				
Comment Code					
E4 : Repair the levee slope damaged by livestock and prevent large animal access.					
Inspector Comment					
There is slope erosion from livestock, the slope is no longer 3:1.

View of damage to the waterside slope looking downstream. (Fall 2022)

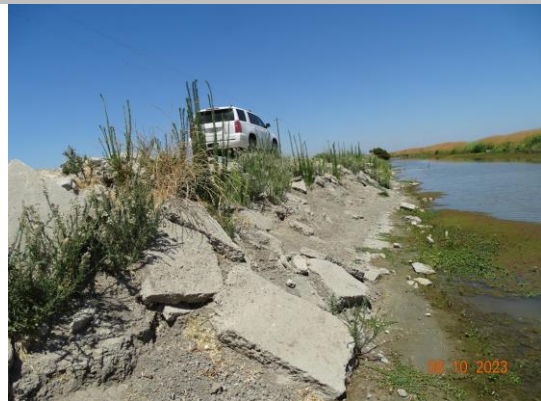
Photo 1 of 1 : SP_2024_NA0010_138_1_20240212_00001.jpg

LM Start	2.65	Rating **	U	Issue No.	1
LM End	2.66	Issue Type +	Ma	Location *	WS
Category	Supplemental			GPS Latitude/Longitude	
				Start	End
Item	DWR Erosion Survey			37.242595°	37.242595°
				-120.706470°	-120.706470°
DWR ID	NA0010U22RM3.87				
Comment Code					
Inspector Comment					
Site ID: NA0010U22RM3.87					
8/10/2023: From 2020 to present, no significant changes were observed during the annual survey.					
08/18/2020: The site has been covered with loose fill and crushed concrete pieces. The erosion will likely worsen again during the next high water.					
09/12/2019: The erosion has cut into the levee prism and damaged almost half of the levee. The livestock traffic has likely caused the erosion.

8/10/2023: View of the erosion with fill and concrete looking downstream.

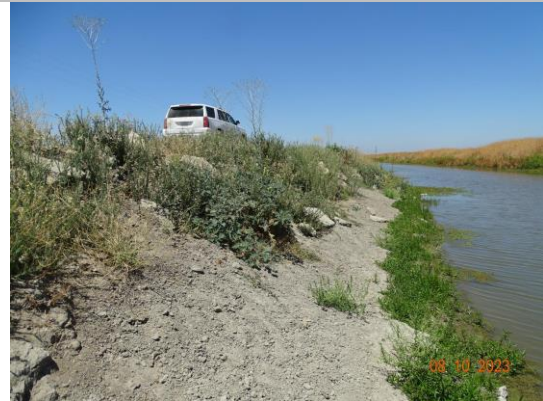
Photo 1 of 1 : SP_2024_NA0010_138_2_20240212_00002.jpg

LM Start	2.82	Rating **	U	Issue No.	2
LM End	2.83	Issue Type +	Ma	Location *	WS
Category	Supplemental			GPS Latitude/Longitude	
				Start	End
Item	DWR Erosion Survey			37.244940°	37.244940°
				-120.707467°	-120.707467°
DWR ID	NA0010U22RM3.7				
Comment Code					
Inspector Comment					
Site ID: NA0010U22RM3.7					
8/10/2023: From 2019 to present, no significant changes were observed during the annual survey. In some areas, the levee shoulder width is up to 8 ft. There is some crushed concrete on the levee slope.					
09/12/2019: The erosion has damaged entire levee slope. The livestock traffic likely has caused the erosion.

8/10/2023: View of the erosion looking downstream.

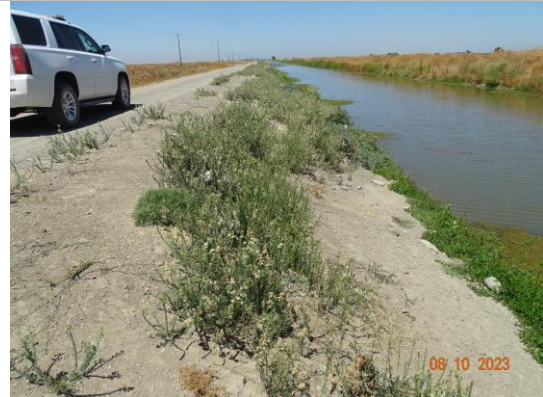
Photo 1 of 1 : SP_2024_NA0010_138_26_20240212_00014.jpg

LM Start	2.87	Rating **	A/W	Issue No.	26
LM End	2.87	Issue Type +	Ma	Location *	WS
Category	Earthen Levee			GPS Latitude/Longitude	
				Start	End
Item	Erosion / Bank Caving			37.245536°	37.245536°
				-120.708119°	-120.708119°
DWR ID	DWR_NA0010_22A_f_2023_26				
Comment Code					
E1 : Note and monitor erosion site.					
Inspector Comment					
Site ID: NA0010U22RM3.65 10/30/23: Issue transferred from Erosion Survey and will continue to be monitored. 08/03/2022: From 2021 to present, no significant changes were observed during the annual survey. 08/18/2020: No vegetation visible in the area of the erosion. Noticed some crushed concrete pieces on the levee slope and a small amount of loose fill. 09/12/2019: The erosion has damaged entire levee slope. The livestock traffic likely has caused the erosion.

View of erosion on the waterside slope. (Fall 2023)

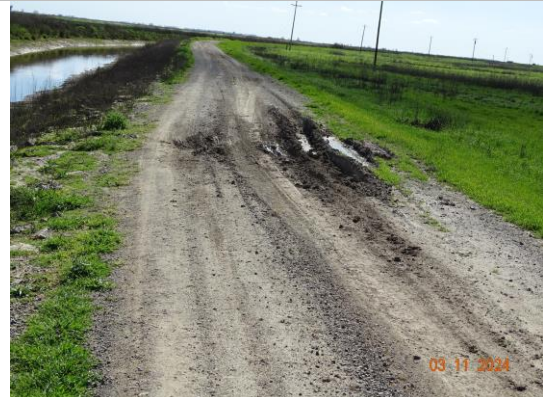
Photo 1 of 1 : SP_2024_NA0010_138_32_20240327_00029.jpg

LM Start	2.94	Rating **	M	Issue No.	32
LM End	2.94	Issue Type +	Ma	Location *	CR
Category	Earthen Levee			GPS Latitude/Longitude	
				Start	End
Item	Crown Surface / Depressions / Rutting			37.246217°	37.246217°
				-120.708970°	-120.708970°
DWR ID	DWR_NA0010_22A_f_2023_32				
Comment Code					
C2 : Repair depressions or ruts in the crown or slope.					
Inspector Comment

View of rutting in the levee crown. (Spring 2024)

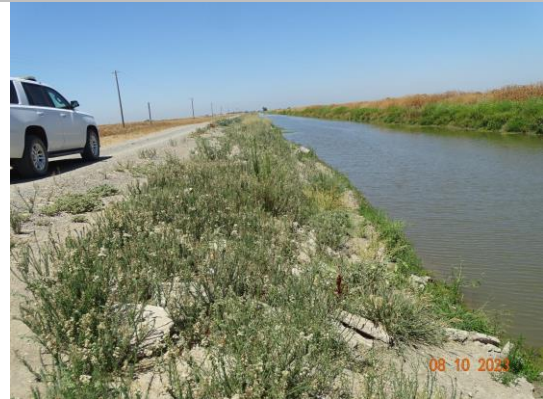
Photo 1 of 1 : SP_2024_NA0010_138_4_20240212_00004.jpg

LM Start	2.96	Rating **	A/W	Issue No.	4
LM End	2.96	Issue Type +	Ma	Location *	WS
Category	Earthen Levee			GPS Latitude/Longitude	
				Start	End
Item	Erosion / Bank Caving			37.246408°	37.246408°
				-120.709197°	-120.709197°
DWR ID	DWR_NA0010_22A_f_2023_4				
Comment Code					
E1 : Note and monitor erosion site.					
Inspector Comment					
Site ID: NA0010U22RM3.56 10/30/23: Issue transferred from Erosion Survey and will continue to be monitored. 08/03/2022: From 2021 to present, no significant changes were observed during the annual survey. 08/18/2020: The erosion has been covered with loose fill and crushed concrete pieces. A nearly vertical slope remains at the levee toe in some sections. The site will likely worsen again during the next high water. 09/12/2019: The erosion has damaged entire levee slope. The livestock activity likely has caused the erosion.

View of erosion site on the waterside slope. (Fall 2023)

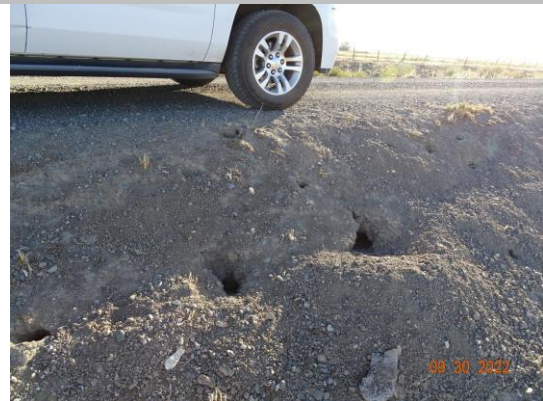
Photo 1 of 1 : SP_2024_NA0010_138_30_20240212_00017.jpg

LM Start	3.38	Rating **	M	Issue No.	30
LM End	3.38	Issue Type +	Ma	Location *	LS
Category	Earthen Levee			GPS Latitude/Longitude	
				Start	End
Item	Animal Control			37.250687 °	37.250687 °
				-120.714559 °	-120.714559 °
DWR ID	DWR_NA0010_22A_f_2022_30				
Comment Code					
A3 : No rodents visible, but rodent burrows visible; need to backfill and compact or grout burrows.					
Inspector Comment

View of rodent holes in the landside slope. (Fall 2022)

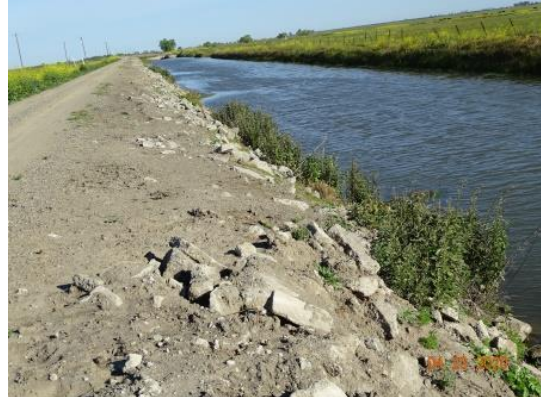
Photo 1 of 1 : SP_2024_NA0010_138_34_20240212_00019.jpg

LM Start	3.44	Rating **	U	Issue No.	34
LM End	3.44	Issue Type +	Ma	Location *	WS
Category	Earthen Levee			GPS Latitude/Longitude	
				Start	End
Item	Erosion / Livestock			37.251370°	37.251370°
				-120.715344°	-120.715344°
DWR ID	DWR_NA0010_22A_f_2018_34				
Comment Code					
E4 : Repair the levee slope damaged by livestock and prevent large animal access.					
Inspector Comment					
Broken concrete was placed on the waterside slope to prevent erosion from livestock. Concrete with rebar should be removed.

Fill and concrete were placed to repair erosion on the waterside slope. Concrete with rebar should be removed. (Spring 2020)

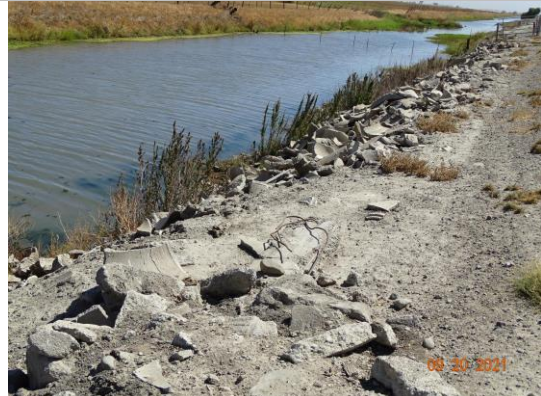
Photo 1 of 1 : SP_2024_NA0010_138_35_20240212_00020.jpg

LM Start	3.47	Rating **	U	Issue No.	35
LM End	3.50	Issue Type +	Ma	Location *	WS
Category	Earthen Levee			GPS Latitude/Longitude	
				Start	End
Item	Erosion / Livestock			37.251621°	37.251978°
				-120.715649°	-120.716143°
DWR ID	DWR_NA0010_22A_f_2018_35				
Comment Code					
E4 : Repair the levee slope damaged by livestock and prevent large animal access.					
Inspector Comment					
Waterside slope erosion is from livestock activity. Slope stabilized with broken concrete. Concrete with rebar in it should be removed.

Fill and concrete placed on the waterside slope. Rebar should be removed for safety. (Fall 2021)

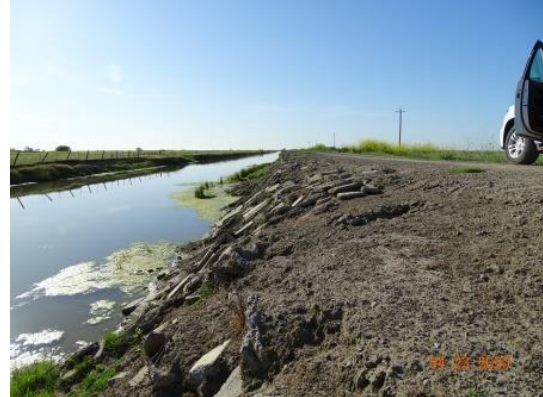
Photo 1 of 1 : SP_2024_NA0010_138_9_20240212_00007.jpg

LM Start	3.64	Rating **	A/W	Issue No.	9
LM End	3.69	Issue Type +	Ma	Location *	WS
Category	Earthen Levee			GPS Latitude/Longitude	
				Start	End
Item	Erosion / Livestock			37.253362°	37.253862°
				-120.717873°	-120.718507°
DWR ID	DWR_NA0010_22A_f_2016_9				
Comment Code					
E4 : Repair the levee slope damaged by livestock and prevent large animal access.					
Inspector Comment					
Broken concrete has been placed to limit further erosion caused by livestock. Continue to monitor.

View of waterside slope looking upstream. (Spring 2020)

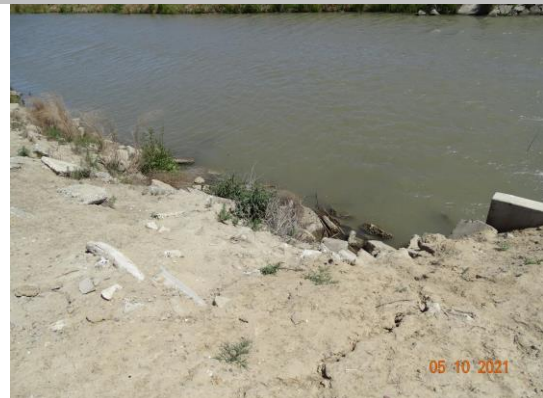
Photo 1 of 1 : SP_2024_NA0010_138_14_20240212_00008.jpg

LM Start	3.82	Rating **	M	Issue No.	14
LM End	3.82	Issue Type +	Ma	Location *	WS
Category	Earthen Levee			GPS Latitude/Longitude	
				Start	End
Item	Erosion / Livestock			37.255239°	37.255239°
				-120.720142°	-120.720142°
DWR ID	DWR_NA0010_22A_f_2017_14				
Comment Code					
E4 : Repair the levee slope damaged by livestock and prevent large animal access.					
Inspector Comment					
Broken concrete previously placed to stabilize the slope has washed out.

Damage to the waterside slope. (Spring 2021)

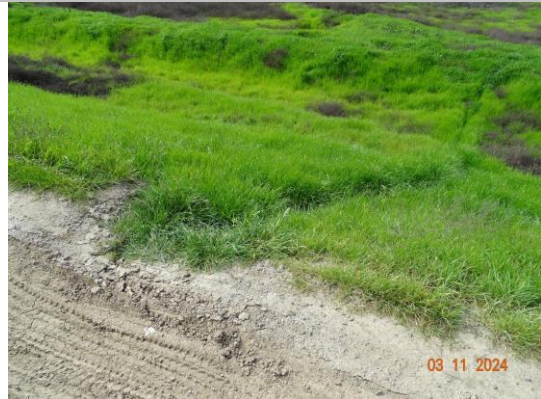
Photo 1 of 1 : SP_2024_NA0010_138_15_20240327_00030.jpg

LM Start	4.11	Rating **	M	Issue No.	15
LM End	4.11	Issue Type +	Ma	Location *	LS
Category	Earthen Levee			GPS Latitude/Longitude	
				Start	End
Item	Erosion / Livestock			37.258353°	37.258353°
				-120.723824°	-120.723824°
DWR ID	DWR_NA0010_22A_f_2019_15				
Comment Code					
E4 : Repair the levee slope damaged by livestock and prevent large animal access.					
Inspector Comment

View of erosion in the landside slope and shoulder from livestock traffic. (Spring 2024)

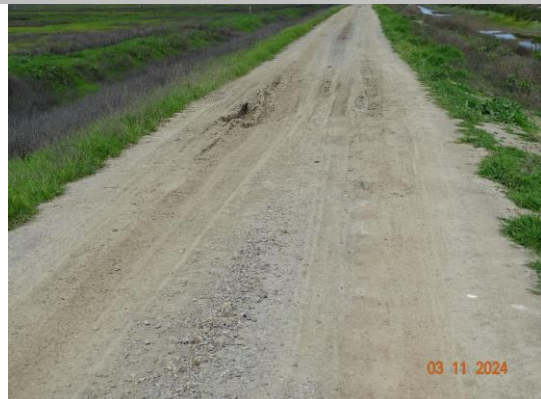
Photo 1 of 1 : SP_2024_NA0010_138_17_20240327_00031.jpg

LM Start	4.13	Rating **	M	Issue No.	17
LM End	4.13	Issue Type +	Ma	Location *	CR
Category	Earthen Levee			GPS Latitude/Longitude	
				Start	End
Item	Crown Surface / Depressions / Rutting			37.258490°	37.258490°
				-120.724015°	-120.724015°
DWR ID	DWR_NA0010_22A_s_2024_17				
Comment Code					
C2 : Repair depressions or ruts in the crown or slope.					
Inspector Comment

View of rutting in the levee crown. (Spring 2024)

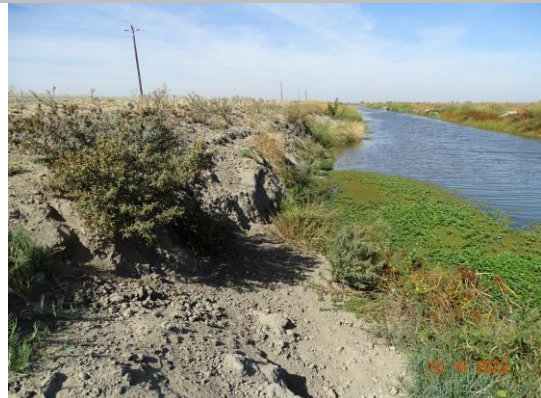
Photo 1 of 1 : SP_2024_NA0010_138_31_20240212_00018.jpg

LM Start	4.21	Rating **	U	Issue No.	31
LM End	4.21	Issue Type +	Ma	Location *	WS
Category	Earthen Levee			GPS Latitude/Longitude	
				Start	End
Item	Erosion / Livestock			37.259370°	37.259370°
				-120.725012°	-120.725012°
DWR ID	DWR_NA0010_22A_f_2023_31				
Comment Code					
E4 : Repair the levee slope damaged by livestock and prevent large animal access.					
Inspector Comment

View of levee waterside slope erosion looking downstream. (Fall 2023)

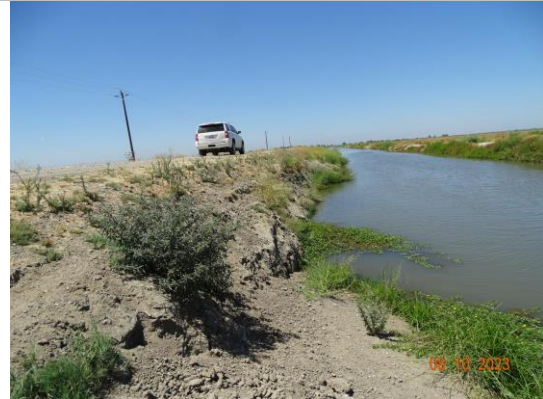
Photo 1 of 1 : SP_2024_NA0010_138_3_20240212_00003.jpg

LM Start	4.26	Rating **	U	Issue No.	3
LM End	4.30	Issue Type +	Ma	Location *	WS
Category	Supplemental			GPS Latitude/Longitude	
				Start	End
Item	DWR Erosion Survey			37.260111°	37.260111°
				-120.725900°	-120.725900°
DWR ID	NA0010U22RM2.25				
Comment Code					
Inspector Comment					
Site ID: NA0010U22RM2.25					
8/10/2023: From 2019 to present, no significant changes were observed during the annual survey.					
09/12/2019: Erosion has developed into the lower levee slope. Loose material was observed at the site.

8/10/2023: View of the erosion looking downstream.

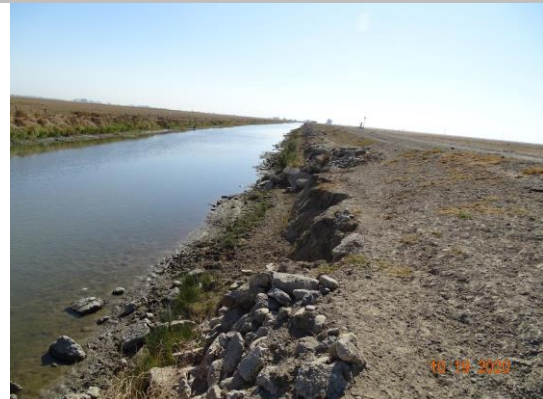
Photo 1 of 1 : SP_2024_NA0010_138_37_20240212_00021.jpg

LM Start	4.30	Rating **	U	Issue No.	37
LM End	5.11	Issue Type +	Ma	Location *	WS
Category	Earthen Levee			GPS Latitude/Longitude	
				Start	End
Item	Erosion / Livestock			37.260111°	37.268135°
				-120.725900°	-120.737130°
DWR ID	DWR_NA0010_22A_f_2018_37				
Comment Code					
E4 : Repair the levee slope damaged by livestock and prevent large animal access.					
Inspector Comment					
Erosion is cutting into the waterside slope. Some sections have been stabilized with cobble stone and broken concrete.

View of waterside slope damage looking upstream. (Fall 2020)

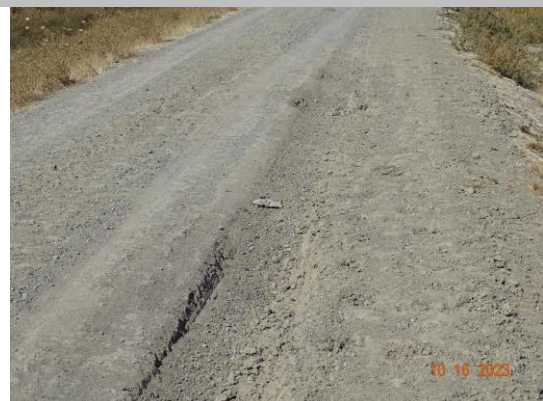
Photo 1 of 1 : SP_2024_NA0010_138_8_20240212_00006.jpg

LM Start	4.36	Rating **	M	Issue No.	8
LM End	4.36	Issue Type +	Ma	Location *	CR
Category	Earthen Levee			GPS Latitude/Longitude	
				Start	End
Item	Crown Surface / Depressions / Rutting			37.260919°	37.260919°
				-120.726838°	-120.726838°
DWR ID	DWR_NA0010_22A_f_2023_8				
Comment Code					
C2 : Repair depressions or ruts in the crown or slope.					
Inspector Comment

View of rutting in the levee crown. (Fall 2023)

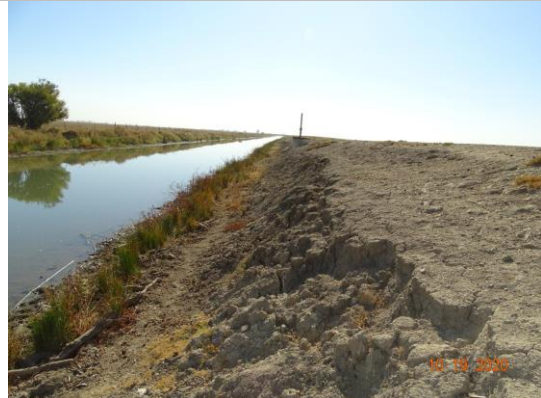
Photo 1 of 1 : SP_2024_NA0010_138_6_20240212_00005.jpg

LM Start	5.12	Rating **	M	Issue No.	6
LM End	5.49	Issue Type +	Ma	Location *	WS
Category	Earthen Levee			GPS Latitude/Longitude	
				Start	End
Item	Erosion / Livestock			37.268236°	37.272262°
				-120.737210°	-120.741778°
DWR ID	DWR_NA0010_22A_s_2022_6				
Comment Code					
E4 : Repair the levee slope damaged by livestock and prevent large animal access.					
Inspector Comment					
Slope damage is caused by livestock on waterside toe.

Looking southeast at livestock erosion on waterward toe. (Fall 2020)

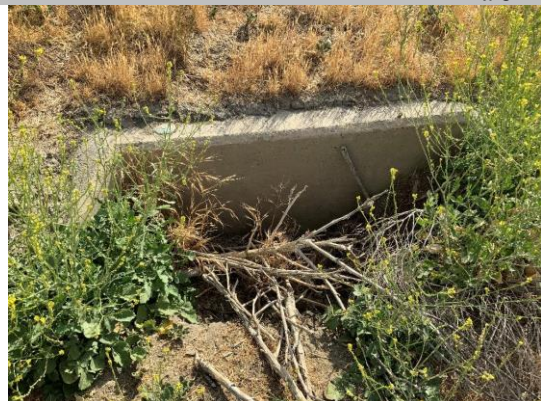
Photo 2 of 2 : UCIP_SP_2024_73519_103920.jpg

Comment Code						
Inspector Comment						
DS_ID:19938 FS_ID:73519 EP_NO: N/A Repair Type: Non-Urgent EVAL Issue: 11, Maintenance Compliance Issue Crossing Status: Found UCIP Comments: 06/09/2021 The record remains Non-Urgent. Appears abandoned due to the LS headwall being buried in sediment and debris buildup, recommend clearing out. Inlet pipe on WS is not visible due to water in channel at the time of the survey. Limited inspection on both WS and LS pipe inlet/outlet. No permit was found authorizing this encroachment. CVFPB will need to review crossing to determine owner. The UCIP inspection was completed with GEI staff, H.Dunn. (P.Espinoza – GEI) 04/15/2014 Need to contact owner. Pipe silted in on LS toe. Appears abandoned and if so should be done so properly. (W. Wylie - DWR UCIP) FIELD_STRUCT_DESC: 48-inch corrugated metal irrigation siphon pipe (CMP) through the levee, 10.0 feet below the crown. Slide gate in a 60-inch CMP riser unit on the waterside (WS) slope. Concrete headwall on the landside (LS) end. WS end capped with a 0.25-inch steel plate. [Additional Reference(s): DWR Levee Log, 2002, (HLM 5.48). USACE San Joaquin O&M Manual, Unit No. 601, Part No. 1, 1967, Amended in 1978, Revised 20 June 1985, (HLM 5.48). DWR As-Built Specification No. 63-25, Sheet No. 19, 9 May 1963, (HLM 5.48)]. FS Date: 6/9/2021 3:14:00 PM

LS view: Closeup of buried concrete headwall at toe.
