Flood Control Project Maintenance
Levee Inspections
LMA District Cover Sheet

Lower San Joaquin Levee District

**Flood Control Project Maintenance
Levee Inspections
Unit Cover Sheet**

Levee Inspection Report By Mile - Spring 2024

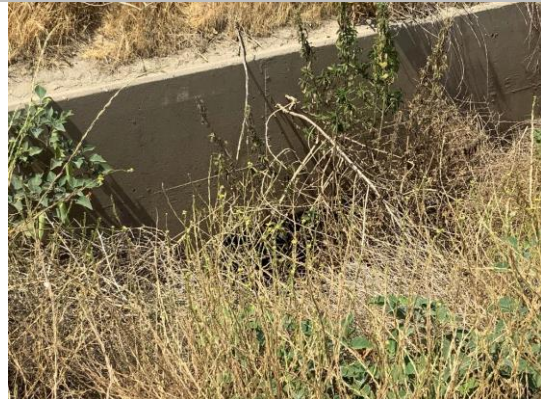
Photo 1 of 1 : UCIP_SP_2024_77877_102579.jpg

Comment Code						
Inspector Comment						
DS_ID:19945 FS_ID:77877 EP_NO: N/A Repair Type: Urgent EVAL Issue: 1, Pipe Integrity Crossing Status: Found UCIP Comments: 12/14/2022 Record updated from Non-Urgent to Urgent. DMP internal video inspection has found pipe integrity issues. LOF of crossing is between 5 and 6. Crossing will be monitored until funding becomes available to address the issues. (O.Yakimov - DWR UCIP) 07/19/2021 The record remains Non-Urgent. Dense LS vegetation over pipe inlet, recommend removal. No permit was found authorizing this encroachment. CVFPB will need to review crossing to determine owner. The UCIP inspection was completed with GEI staff, P. Espinoza. (H. Dunn – GEI) 04/03/2014 Excessive vegetation at inlet--recommend clearing. (W. Wylie - DWR UCIP) FIELD_STRUCT_DESC: 30-inch by 30-inch square reinforced concrete box gravity drainage culvert (RCBC) through the levee, 13.0 feet below the crown. Flap gate on the waterside (WS) end. Concrete headwall on the landside (LS) end. Concrete U-shaped headwall on the WS end. (Construction of a new discharge structure and rehabilitation of an existing diversion structure to return intercepted seepage to the San Joaquin River authorized under Permit No. 13085, 1981 - Diener, Dry River Farms). [Additional Reference(s): DWR Levee Log, 2002, (HLM 0.21). USACE San Joaquin O&M Manual, Unit No. 601, Part No. 1, 1967, Amended in 1978, Revised 20 June 1985, (HLM 0.21). DWR As-Built Specification No. 65-30, Sheet No. 7, 27 April 1965, (HLM 0.21), listed as 2'- 6" x 2'- 6" drainage structure]. FS Date: 7/19/2021 3:07:37 PM

LS view: Closeup of pipe inlet at toe covered with vegetation.

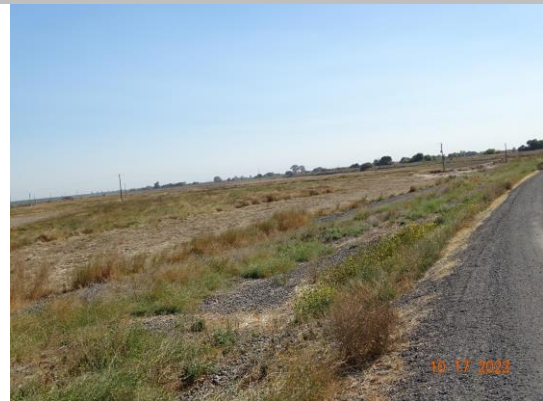
Photo 1 of 1 : SP_2024_NA0010_139_38_20240212_00006.jpg

LM Start	0.73	Rating **	A/W	Issue No.	38
LM End	1.51	Issue Type +	Ob	Location *	LS
Category	Earthen Levee			GPS Latitude/Longitude	
				Start	End
Item	Seepage / Sandboils			36.774702°	36.772158°
				-120.272638°	-120.259719°
DWR ID	DWR_NA0010_23_f_2023_38				
Comment Code					
SS : Seepage / Sandboils					
Inspector Comment					
Seepage blanket on landside toe installed during 2023 storms.

View of seepage blanket along the landside toe. (Fall 2023)

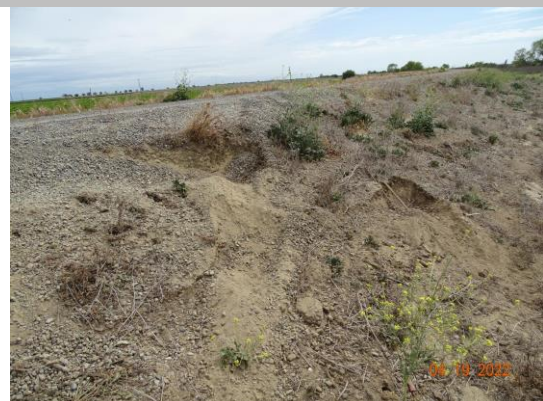
Photo 1 of 1 : SP_2024_NA0010_139_40_20240212_00007.jpg

LM Start	1.00	Rating **	M	Issue No.	40
LM End	1.00	Issue Type +	Ma	Location *	WS
Category	Earthen Levee			GPS Latitude/Longitude	
				Start	End
Item	Erosion / Vehicle Traffic			36.772875°	36.772875°
				-120.268436°	-120.268436°
DWR ID	DWR_NA0010_23_s_2022_40				
Comment Code					
E6 : Repair the levee slope damaged by vehicle traffic and prevent access where possible.					
Inspector Comment

Damage from vehicle traffic to the waterside slope. (Spring 2022)

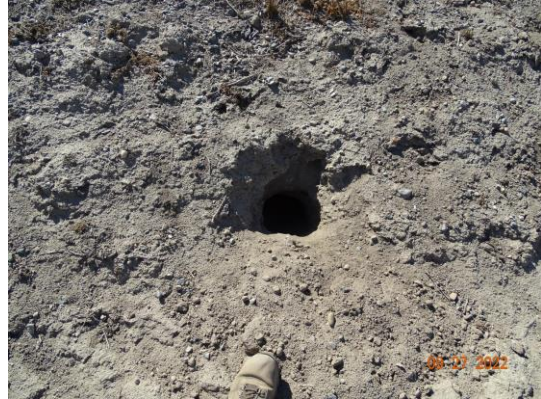
Photo 1 of 1 : SP_2024_NA0010_139_43_20240212_00009.jpg

LM Start	2.24	Rating **	A/W	Issue No.	43
LM End	2.24	Issue Type +	Ma	Location *	LS
Category	Earthen Levee			GPS Latitude/Longitude	
				Start	End
Item	Animal Control			36.775659 °	36.775659 °
				-120.249645 °	-120.249645 °
DWR ID	DWR_NA0010_23_f_2022_43				
Comment Code					
A3 : No rodents visible, but rodent burrows visible; need to backfill and compact or grout burrows.					
Inspector Comment

Large animal hole in the landside slope. (Fall 2022)

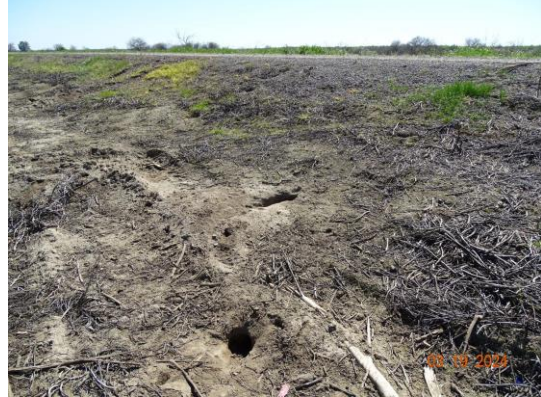
Photo 1 of 1 : SP_2024_NA0010_139_22_20240327_00036.jpg

LM Start	2.84	Rating **	M	Issue No.	22
LM End	2.84	Issue Type +	Ma	Location *	LS
Category	Earthen Levee			GPS Latitude/Longitude	
				Start	End
Item	Animal Control			36.771568°	36.771568°
				-120.240941°	-120.240941°
DWR ID	DWR_NA0010_23_s_ 2024_22				
Comment Code					
A3 : No rodents visible, but rodent burrows visible; need to backfill and compact or grout burrows.					
Inspector Comment

View of multiple rodent burrows on the landside slope. (Spring 2024)

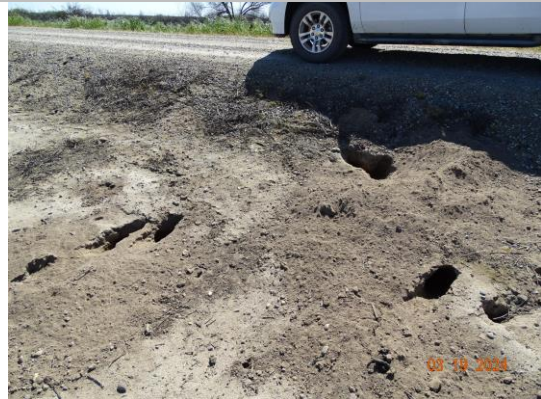
Photo 1 of 1 : SP_2024_NA0010_139_27_20240327_00037.jpg

LM Start	4.34	Rating **	M	Issue No.	27
LM End	4.34	Issue Type +	Ma	Location *	LS
Category	Earthen Levee			GPS Latitude/Longitude	
				Start	End
Item	Animal Control			36.783871°	36.783871°
				-120.225046°	-120.225046°
DWR ID	DWR_NA0010_23_s_2024_27				
Comment Code					
A3 : No rodents visible, but rodent burrows visible; need to backfill and compact or grout burrows.					
Inspector Comment

Multiple rodent holes observed at this section. (Spring 2024)

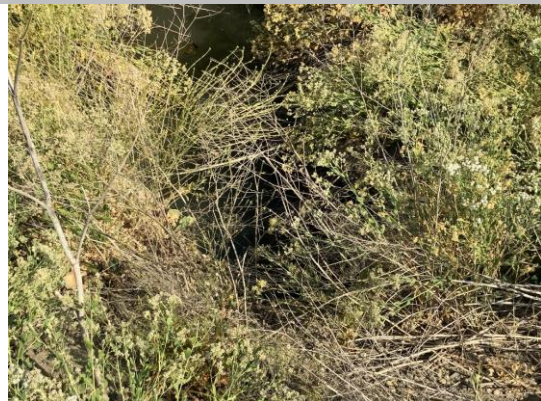
Photo 1 of 1 : UCIP_SP_2024_73581_102608.jpg

Comment Code					
Inspector Comment					
DS_ID:19953 FS_ID:73581 EP_NO: N/A Repair Type: Non-Urgent EVAL Issue: 11, Maintenance Compliance Issue Crossing Status: Found UCIP Comments: 07/19/2021 The record remains Non-Urgent. WS pipe inlet underwater during inspection. LS pipe outlet not visible due to dense vegetation, recommend removing vegetation. Limited inspection on both WS and LS ends. No permit was found authorizing this encroachment. CVFPB will need to review crossing to determine owner. The UCIP inspection was completed with GEI staff, P. Espinoza. (H. Dunn – GEI) 04/03/2014 Heavy vegetation at inlet and outlet-- recommend clearing. (W. Wylie - DWR UCIP) FIELD_STRUCT_DESC: 30-inch by 30-inch square reinforced concrete box gravity irrigation culvert (RCBC) through the levee, 10.7 feet below the crown. 4.5-foot by 7-foot concrete riser unit with slide gate on the waterside (WS) slope. Concrete U-shaped headwall on each end. 15-foot-long cobble revetted inlet channel. [Additional Reference(s): DWR Levee Log, 2002, (HLM 4.87)]. FS Date: 7/19/2021

LS view: Pipe outlet covered by dense vegetation at toe.

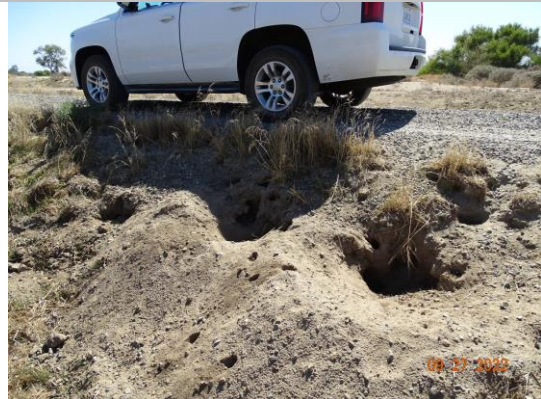
Photo 1 of 1 : SP_2024_NA0010_139_50_20240212_00014.jpg

LM Start	5.21	Rating **	U	Issue No.	50
LM End	5.21	Issue Type +	Ma	Location *	LS
Category	Earthen Levee			GPS Latitude/Longitude	
				Start	End
Item	Animal Control			36.791383°	36.791383°
				-120.214560°	-120.214560°
DWR ID	DWR_NA0010_23_f_2022_50				
Comment Code					
A3 : No rodents visible, but rodent burrows visible; need to backfill and compact or grout burrows.					
Inspector Comment

Multiple large animal burrows on the landside slope. (Fall 2022)

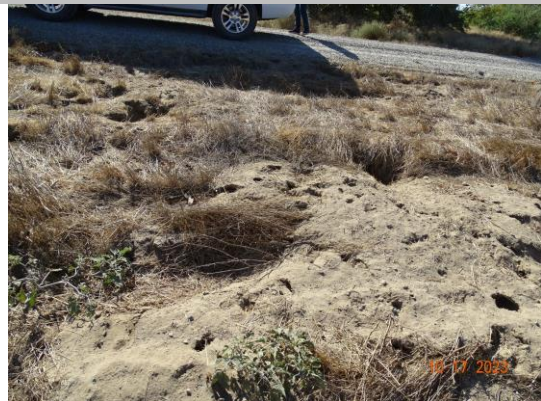
Photo 1 of 1 : SP_2024_NA0010_139_44_20240212_00010.jpg

LM Start	5.45	Rating **	U	Issue No.	44
LM End	5.45	Issue Type +	Ma	Location *	LS
Category	Earthen Levee			GPS Latitude/Longitude	
				Start	End
Item	Animal Control			36.791818°	36.791818°
				-120.210281°	-120.210281°
DWR ID	DWR_NA0010_23_f_2023_44				
Comment Code					
A3 : No rodents visible, but rodent burrows visible; need to backfill and compact or grout burrows.					
Inspector Comment

Several large rodent holes observed in the landside toe. (Fall 2023)

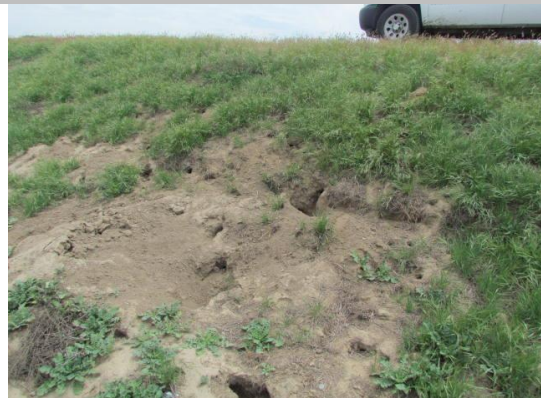
Photo 1 of 1 : SP_2024_NA0010_139_5_20240212_00001.jpg

LM Start	5.68	Rating **	M	Issue No.	5
LM End	5.68	Issue Type +	Ma	Location *	LS
Category	Earthen Levee			GPS Latitude/Longitude	
				Start	End
Item	Animal Control			36.791981°	36.791981°
				-120.206274°	-120.206274°
DWR ID	DWR_NA0010_23_s_2012_5				
Comment Code					
A1 : Exterminate rodents and backfill and compact or grout burrows.					
Inspector Comment					
There are several large rodent holes in this area.

Looking at several rodent holes on landside slope.

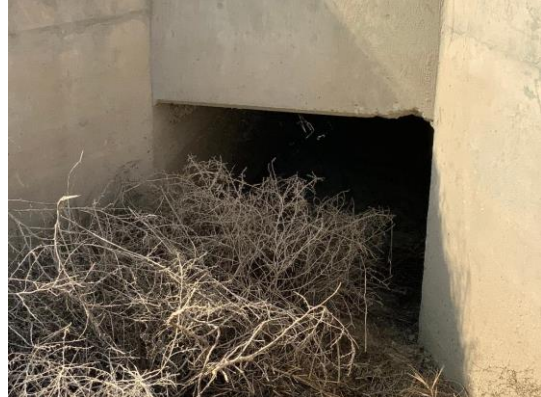
Photo 1 of 1 : UCIP_SP_2024_73582_102645.jpg

Comment Code						
Inspector Comment						
DS_ID:19954 FS_ID:73582 EP_NO: N/A Repair Type: Non-Urgent EVAL Issue: 11, Maintenance Compliance Issue Crossing Status: Found UCIP Comments: 07/19/2021 The record remains Non-Urgent. LS has sediment buildup in pipe inlet and buildup of tumbleweeds around pipe inlet, recommend clearing out. No permit was found authorizing this encroachment. CVFPB will need to review crossing to determine owner. The UCIP inspection was completed with GEI staff, P. Espinoza. (H. Dunn – GEI) 04/03/2014 Dense vegetation limits the inspector's visibility to identify signs of pipe failure (leaks) along the landward slope. Recommend removing vegetation along pipe alignment to conduct proper inspection of structure. (W. Wylie - DWR UCIP) FIELD_STRUCT_DESC: 36-inch by 36-inch square reinforced concrete box gravity drainage culvert (RCBC) through the levee, 9.0 feet below the crown. Flap gate on the waterside (WS) end. Concrete U-shaped headwall on each end. 5-foot-long cobble revetted outlet channel. [Additional Reference(s): DWR Levee Log, 2002, (HLM 5.71). USACE San Joaquin O&M Manual, Unit No. 601, Part No. 1, 1967, Amended in 1978, Revised 20 June 1985, (HLM 5.71). DWR As-Built Specification No. 65-30, Sheet No. 13, 27 April 1965, (HLM 5.71)]. FS Date: 7/19/2021

LS view: Closeup of pipe inlet at toe with sediment and tumbleweed buildup.

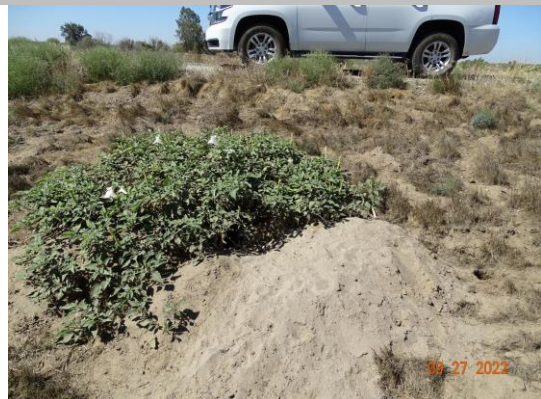
Photo 1 of 1 : SP_2024_NA0010_139_51_20240212_00015.jpg

LM Start	6.10	Rating **	U	Issue No.	51
LM End	6.10	Issue Type +	Ma	Location *	LS
Category	Earthen Levee			GPS Latitude/Longitude	
				Start	End
Item	Animal Control			36.788806°	36.788806°
				-120.200824°	-120.200824°
DWR ID	DWR_NA0010_23_f_2022_51				
Comment Code					
A3 : No rodents visible, but rodent burrows visible; need to backfill and compact or grout burrows.					
Inspector Comment

View of rodent burrow underneath vegetation growth on the landside slope. (Fall 2022)

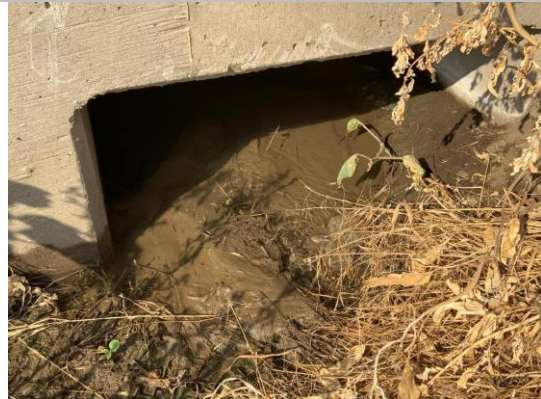
Photo 1 of 1 : UCIP_SP_2024_77874_102659.jpg

Comment Code						
Inspector Comment						
DS_ID:19939 FS_ID:77874 EP_NO: N/A Repair Type: Urgent EVAL Issue: 1, Pipe Integrity Crossing Status: Found UCIP Comments: 12/14/2022 Record updated from Non-Urgent to Urgent. DMP internal video inspection has found pipe integrity issues. LOF of crossing is between 5 and 6. Crossing will be monitored until funding becomes available to address the issues. (O.Yakimov - DWR UCIP) 07/19/2021 The record remains Non-Urgent. LS pipe inlet almost completely filled with sediment, recommend removal. Water running through WS flapgate during inspection and wooden plank keeping WS flapgate closed, recommend removal before flood season for better flow. No permit was found authorizing this encroachment. CVFPB will need to review crossing to determine owner. The UCIP inspection was completed with GEI staff, P. Espinoza. (H. Dunn – GEI) 04/03/2014 Dense vegetation limits the inspector's visibility to identify signs of pipe failure (leaks) along the landward slope. Recommend removing vegetation along pipe alignment to conduct proper inspection of structure. (W. Wylie - DWR UCIP) FIELD_STRUCT_DESC: 30-inch by 30-inch square reinforced concrete box gravity drainage culvert (RCBC) through the levee, 8.5 feet below the crown. Flap gate on the waterside (WS) end. Concrete headwall on the landside (LS) end. Concrete U-shaped headwall on the WS end. [Additional Reference(s): DWR Levee Log, 2002, (HLM 7.06)]. FS Date: 7/19/2021 3:06:24 PM

LS view: Closeup of pipe inlet at toe with dense sediment buildup.

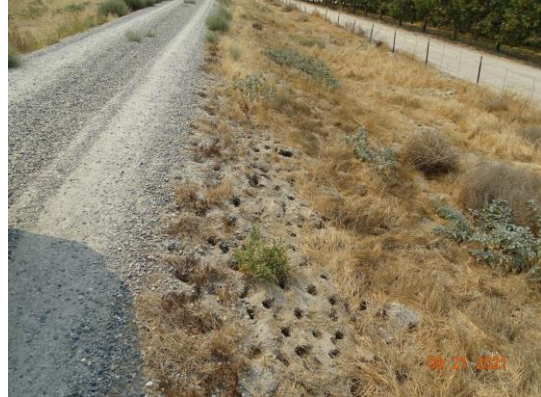
WS view: WS slope profile

LM Start	7.52	Rating **	M	Issue No.	46
LM End	7.72	Issue Type +	Ma	Location *	LS
Category	Earthen Levee			GPS Latitude/Longitude	
				Start	End
Item	Animal Control			36.781983°	36.784231°
				-120.186095°	-120.184096°
DWR ID	DWR_NA0010_23_f_2021_46				
Comment Code					
A3 : No rodents visible, but rodent burrows visible; need to backfill and compact or grout burrows.					
Inspector Comment					
Several burrows in the landside slope.

View of several rodent burrows in the landside slope. (Fall 2021)

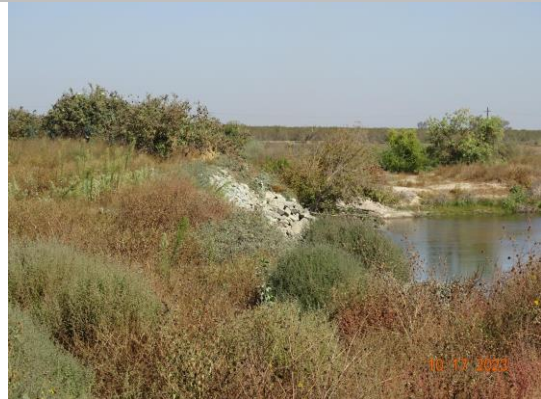
Photo 1 of 1 : SP_2024_NA0010_139_49_20240212_00013.jpg

LM Start	8.06	Rating **	A/W	Issue No.	49
LM End	8.13	Issue Type +	Ma	Location *	WS
Category	Earthen Levee			GPS Latitude/Longitude	
				Start	End
Item	Riprap Revetments			36.788957°	36.789846°
				-120.182361°	-120.182235°
DWR ID	DWR_NA0010_23_f_2023_49				
Comment Code					
RR : Riprap Revetments					
Inspector Comment

View of rock slope protection placed on the waterside berm. (Fall 2023)

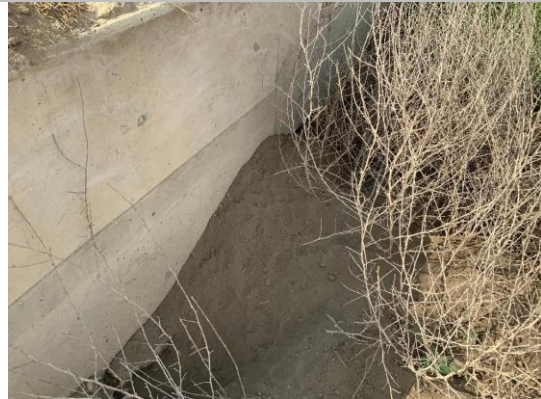
Photo 1 of 3 : UCIP_SP_2024_77875_102672.jpg

DS_ID:19940
FS_ID:77875
EP_NO: N/A
Repair Type: Urgent
EVAL Issue: 1, Pipe Integrity
Crossing Status: Found
UCIP Comments: 12/14/2022 Record updated from Non-Urgent to Urgent. DMP internal video inspection has found pipe integrity issues. LOF of crossing is between 5 and 6. Crossing will be monitored until funding becomes available to address the issues. (O.Yakimov - DWR UCIP)
07/19/2021 The record remains Non-Urgent. LS pipe inlet almost completely covered by sediment, recommend clearing out. Some minor erosion along one side of the WS headwall as well as some burrow complexes on the slope adjacent to same headwall side. No permit was found authorizing this encroachment. CVFPB will need to review crossing to determine owner. The UCIP inspection was completed with GEI staff, P. Espinoza. (H. Dunn – GEI) 04/03/2014 Some sediment buildup at inlet at LS toe. Also dense vegetation limits the inspector's visibility to identify signs of pipe failure (leaks) along the landward slope. Recommend removing vegetation along pipe alignment to conduct proper inspection of structure. (W. Wylie - DWR UCIP)

LS view: Closeup of pipe inlet blocked by sediment.

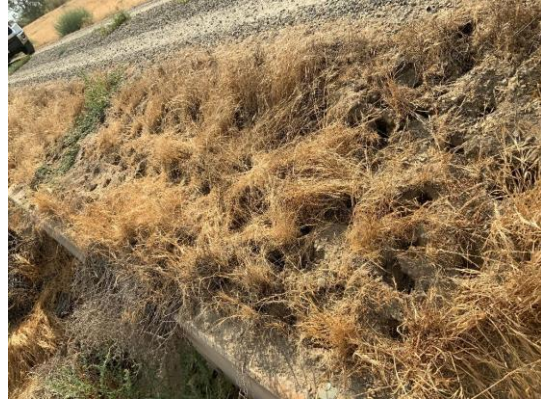
Photo 1 of 2 : UCIP_SP_2024_77876_102681.jpg

Comment Code						
Inspector Comment						
DS_ID:19941 FS_ID:77876 EP_NO: N/A Repair Type: Urgent EVAL Issue: 1, Pipe Integrity Crossing Status: Found UCIP Comments: 12/14/2022 Record updated from Non-Urgent to Urgent. DMP internal video inspection has found pipe integrity issues. LOF of crossing is between 5 and 6. Crossing will be monitored until funding becomes available to address the issues. (O.Yakimov - DWR UCIP) 07/19/2021 The record remains Non-Urgent. LS pipe inlet has sediment buildup inside, recommend removal. Extensive burrows above the LS headwall slope. No permit was found authorizing this encroachment. CVFPB will need to review crossing to determine owner. The UCIP inspection was completed with GEI staff, P. Espinoza. (H. Dunn – GEI) 04/03/2014 Dense vegetation limits the inspector's visibility to identify signs of pipe failure (leaks) along the landward slope. Recommend removing vegetation along pipe alignment to conduct proper inspection of structure. (W. Wylie - DWR UCIP) FIELD_STRUCT_DESC: 30-inch by 30-inch square reinforced concrete box gravity drainage culvert (RCBC) through the levee, 5.6 feet below the crown. Flap gate on the waterside (WS) end. Concrete headwall on the landside (LS) end. Concrete U-shaped headwall on the WS end. [Additional Reference(s): DWR Levee Log, 2002, (HLM 8.53). USACE San Joaquin O&M Manual, Unit No. 601, Part No. 1, 1967, Amended in 1978, Revised 20 June 1985, (HLM 8.54). DWR As-Built Specification No. 65-30, Sheet No. 15, 27 April 1965, (HLM 8.54)]. FS Date: 7/19/2021 3:07:17 PM

LS view: Burrow holes above headwall.

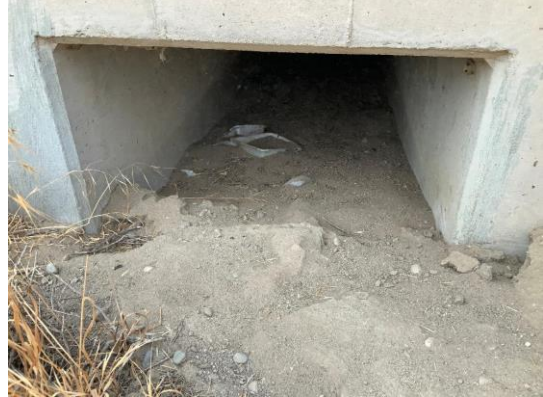
Photo 2 of 2 : UCIP_SP_2024_77876_102675.jpg

LM Start	8.52	Rating **	U	Issue No.	73 (cont)	
LM End	8.52	Issue Type +	Ma	Location *		
Category	Supplemental			GPS Latitude/Longitude		
				Start		End
Item	DWR UCIP LMA Responsibility			36.794108°		36.794108°
				-120.178171°		-120.178171°
DWR ID	19941

LS view: Closeup of pipe inlet at toe with sediment buildup.

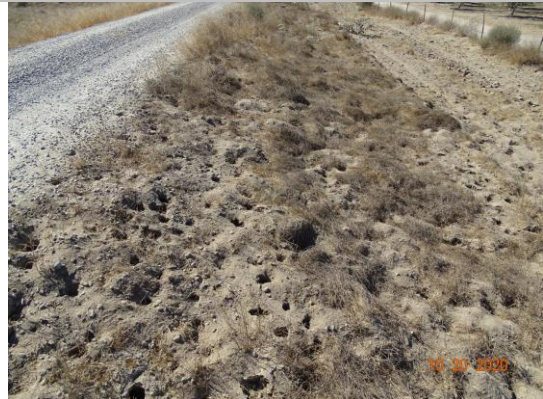
Photo 1 of 1 : SP_2024_NA0010_139_29_20240212_00005.jpg

LM Start	8.55	Rating **	M	Issue No.	29
LM End	8.66	Issue Type +	Ma	Location *	LS
Category	Earthen Levee			GPS Latitude/Longitude	
				Start	End
Item	Animal Control			36.794284°	36.795288°
				-120.177783°	-120.176146°
DWR ID	DWR_NA0010_23_f_2020_29				
Comment Code					
A3 : No rodents visible, but rodent burrows visible; need to backfill and compact or grout burrows.					
Inspector Comment

Several rodent holes observed along this section of the landside slope.
(Fall 2020)

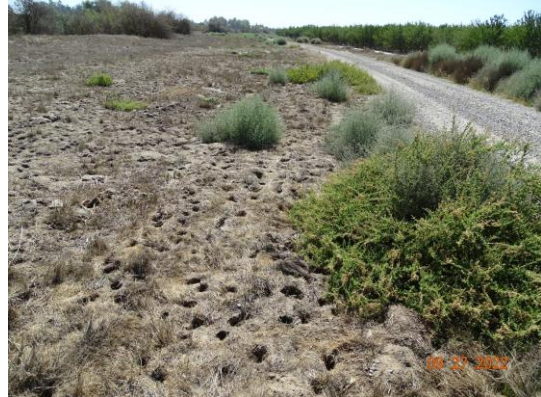
Photo 1 of 1 : SP_2024_NA0010_139_25_20240212_00004.jpg

LM Start	8.97	Rating **	M	Issue No.	25
LM End	8.97	Issue Type +	Ma	Location *	WS
Category	Earthen Levee			GPS Latitude/Longitude	
				Start	End
Item	Animal Control			36.799606°	36.799606°
				-120.175395°	-120.175395°
DWR ID	DWR_NA0010_23_f_2016_25				
Comment Code					
A3 : No rodents visible, but rodent burrows visible; need to backfill and compact or grout burrows.					
Inspector Comment					
There are rodent holes on the waterside shoulder.

Several rodent holes observed on the waterside slope in this section.
(Fall 2022)

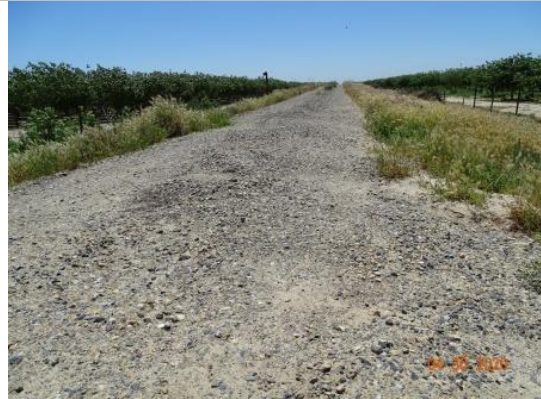
Photo 1 of 1 : SP_2024_NA0010_139_65_20240212_00019.jpg

LM Start	9.74	Rating **	M	Issue No.	65
LM End	9.74	Issue Type +	Ma	Location *	CR
Category	Earthen Levee			GPS Latitude/Longitude	
				Start	End
Item	Crown Surface / Depressions / Rutting			36.807603°	36.807603°
				-120.168825°	-120.168825°
DWR ID	DWR_NA0010_23_s_2019_65				
Comment Code					
C2 : Repair depressions or ruts in the crown or slope.					
Inspector Comment

Depressions forming in the levee crown. (Spring 2020)

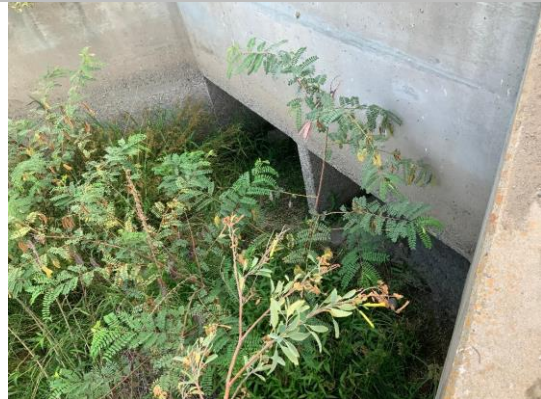
Photo 1 of 2 : UCIP_SP_2024_77382_102710.jpg

Comment Code					
Inspector Comment					
DS_ID:19943 FS_ID:77382 EP_NO: N/A Repair Type: Urgent EVAL Issue: 3a, Flood Risk Crossing Status: Found UCIP Comments: 08/31/2022 Crossing open on both ends with no way to close it as the gates do not work: urgent. (A. McDonald - DWR UCIP)07/19/2021 The record remains Non-Urgent. Limited access to both LS and WS due to steep slopes and vegetation. Both WS outlet and LS inlet have sediment buildup, recommend clearing out. No permit was found authorizing this encroachment. CVFPB will need to review crossing to determine owner. This portion of the levee has a levee prism less than 3 feet, appears to be high ground. The UCIP inspection was completed with GEI staff, P. Espinoza. (H. Dunn – GEI) 11/01/2018 Limited access to both LS and WS; assumed slide gates are still non-functional; Crossing has been downgraded from Urgent to Non-Urgent due to re-classification of damage slide gates. (O. Magana - DWR UCIP)07/20/2016 No change--same as previous inspection. (O. Magana - DWR UCIP)04/03/2014 Slide gate not functional. Slide gate channels heavily corroded (exfoliated) and likely impact functionality/structural integrity of gate. (W. Wylie - DWR UCIP) FIELD_STRUCT_DESC: [Gravelly Ford Canal Irrigation Structure] 1 of 2: 48-inch by 63-inch reinforced concrete box gravity irrigation culvert (RCBC) through the levee, 10.0 feet below the crown. Concrete U-shaped headwall on each end. Gear pedestal slide gate with wall bracket on the waterside (WS) headwall. 10-foot-long cobble revetted outlet channel. Guardrail on each shoulder. Slide gates on the WS. [Additional Reference(s): DWR Levee Log, 2002, (HLM 9.76). USACE San Joaquin O&M Manual, Unit No. 601, Part No. 1, 1967, Amended in 1978, Revised 20 June 1985, (HLM 9.76). DWR As-Built Specification No. 65-30, Sheet No. 16, 27 April 1965, (HLM 9.76)]. FS Date: 7/19/2021

LS view: Closeup of inlets at toe with sediment buildup.

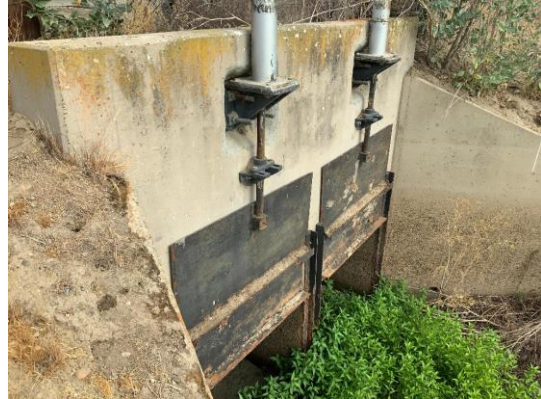
Photo 2 of 2 : UCIP_SP_2024_77382_102713.jpg

LM Start	9.75	Rating **	U	Issue No.	74 (cont)
LM End	9.75	Issue Type +	En	Location *	
Category	Supplemental			GPS Latitude/Longitude	
				Start	End
Item	DWR UCIP Field Study			36.807768 °	36.807768 °
				-120.168848 °	-120.168848 °
DWR ID	19943

WS view: Closeup of slidegates at toe.

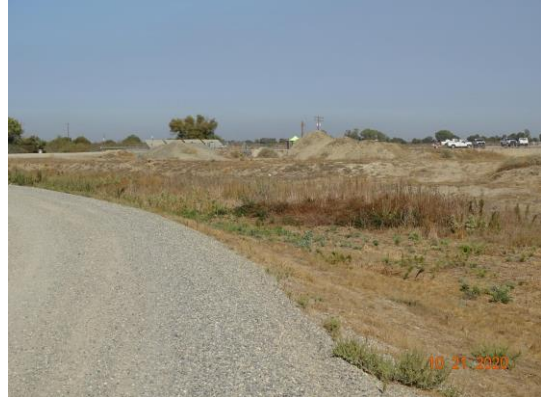
Photo 1 of 1 : SP_2024_NA0010_140_47_20240212_00015.jpg

LM Start	0.06	Rating **	M	Issue No.	47
LM End	0.06	Issue Type +	En	Location *	WS
Category	Earthen Levee			GPS Latitude/Longitude	
				Start	End
Item	Encroachments			36.772328°	36.772328°
				-120.285117°	-120.285117°
DWR ID	DWR_NA0010_24_s_2014_47				
Comment Code					
MA : Material					
Inspector Comment					
The District constructed a berm on waterside slope. The berm is being used for staging of earthen material.

Berm and material constructed off the waterside slope. (Fall 2020)

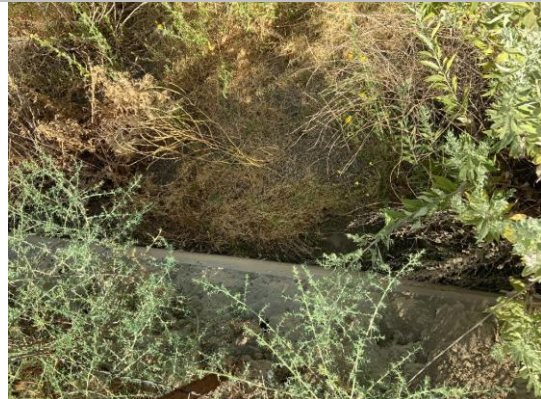
Photo 1 of 2 : UCIP_SP_2024_77878_102764.jpg

Comment Code						
Inspector Comment						
DS_ID:19955 FS_ID:77878 EP_NO: N/A Repair Type: Urgent EVAL Issue: 1, Pipe Integrity Crossing Status: Found UCIP Comments: 12/14/2022 Record updated from Non-Urgent to Urgent. DMP internal video inspection has found pipe integrity issues. LOF of crossing is between 5 and 6. Crossing will be monitored until funding becomes available to address the issues. (O.Yakimov - DWR UCIP) 07/20/2021 The record remains Non-Urgent. Cannot access LS inlet due to barbed wire, but appears to have sediment buildup. WS flapgate inaccessible due to steep hill and dense vegetation, recommend clearing vegetation and sediment out on both WS and LS inlet/outlet. No permit was found authorizing this encroachment. CVFPB will need to review crossing to determine owner. The UCIP inspection was completed with GEI staff, P. Espinoza. (H. Dunn – GEI)04/08/2014 No access available to confirm condition of landward side headwall. Recommend clearing debris along fence. Surface erosion near concrete headwall on landward side was present. (O. Magana - DWR UCIP) FIELD_STRUCT_DESC: 30-inch by 30-inch square reinforced concrete box gravity drainage culvert (RCBC) through the levee, 13.5 feet below the crown. Flap gate on the waterside (WS) end. Concrete headwall on each end. [Additional Reference(s): DWR Levee Log, 2002, (HLM 0.49)]. FS Date: 7/20/2021 3:10:19 PM

LS view: Top of headwall at toe.

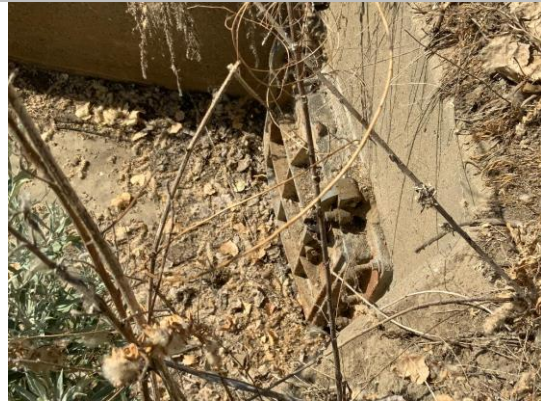
Photo 2 of 2 : UCIP_SP_2024_77878_102761.jpg

LM Start	0.50	Rating **	U	Issue No.	52 (cont)
LM End	0.50	Issue Type +	En	Location *	
Category	Supplemental		GPS Latitude/Longitude		
			Start	End	
Item	DWR UCIP Field Study		36.766872°	36.766872°	
			-120.283212°	-120.283212°	
DWR ID	19955

WS view: Closeup of flapgate at toe.

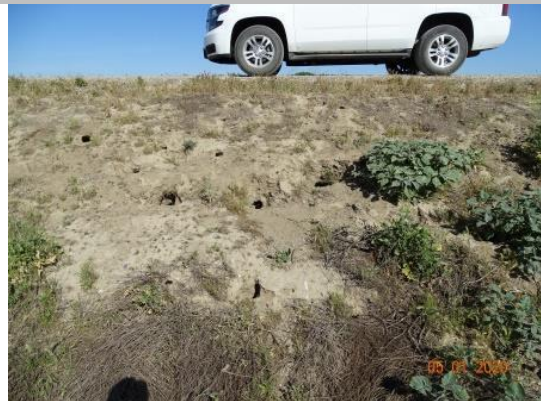
Photo 1 of 1 : SP_2024_NA0010_140_6_20240212_00001.jpg

LM Start	0.80	Rating **	M	Issue No.	6
LM End	0.84	Issue Type +	Ma	Location *	LS
Category	Earthen Levee			GPS Latitude/Longitude	
				Start	End
Item	Animal Control			36.766553°	36.766962°
				-120.278947°	-120.278602°
DWR ID	DWR_NA0010_24_s_2013_6				
Comment Code					
A1 : Exterminate rodents and backfill and compact or grout burrows.					
Inspector Comment					
There are several rodent holes identified within this section.

Rodent burrows in the landside slope. (Spring 2020)

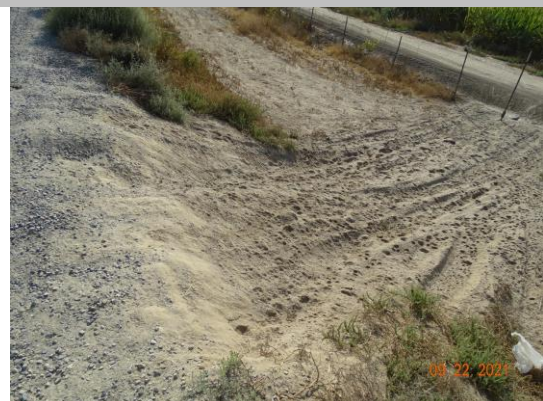
Photo 1 of 1 : SP_2024_NA0010_140_39_20240212_00014.jpg

LM Start	2.77	Rating **	A/W	Issue No.	39
LM End	2.77	Issue Type +	Ma	Location *	LS
Category	Earthen Levee			GPS Latitude/Longitude	
				Start	End
Item	Erosion / Vehicle Traffic			36.772289°	36.772289°
				-120.249693°	-120.249693°
DWR ID	DWR_NA0010_24_f_2021_39				
Comment Code					
E6 : Repair the levee slope damaged by vehicle traffic and prevent access where possible.					
Inspector Comment

View of the vehicle traffic on the landside slope. (Fall 2021)

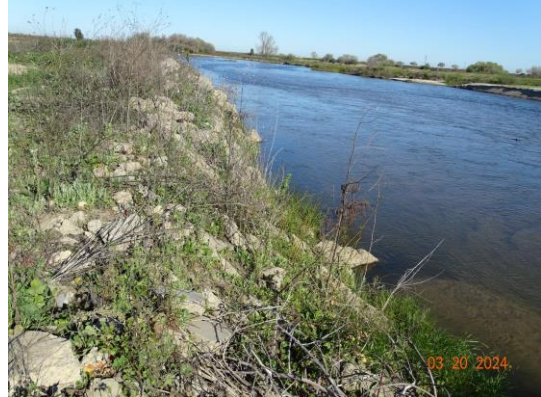
Photo 1 of 1 : SP_2024_NA0010_140_17_20240327_00028.jpg

LM Start	2.79	Rating **	A/W	Issue No.	17
LM End	2.87	Issue Type +	Ma	Location *	WS
Category	Earthen Levee			GPS Latitude/Longitude	
				Start	End
Item	Riprap Revetments			36.772501°	36.771801°
				-120.249368°	-120.248057°
DWR ID	DWR_NA0010_24_s_2024_17				
Comment Code					
RR : Riprap Revetments					
Inspector Comment

View of revetment placed on the waterside slope and berm. (Spring 2024)

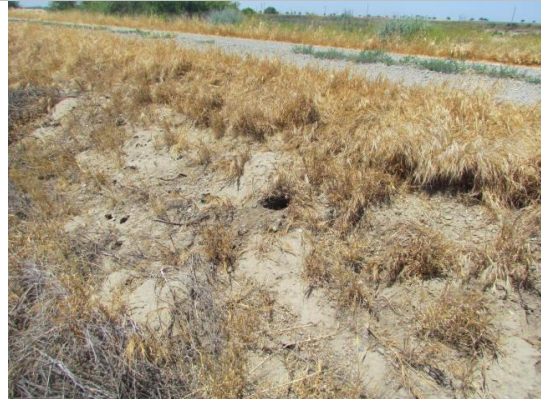
Photo 1 of 1 : SP_2024_NA0010_140_7_20240212_00002.jpg

LM Start	3.46	Rating **	M	Issue No.	7
LM End	3.46	Issue Type +	Ma	Location *	LS
Category	Earthen Levee			GPS Latitude/Longitude	
				Start	End
Item	Animal Control			36.769345°	36.769345°
				-120.238370°	-120.238370°
DWR ID	DWR_NA0010_24_s_2012_7				
Comment Code					
A3 : No rodents visible, but rodent burrows visible; need to backfill and compact or grout burrows.					
Inspector Comment					
There are several rodent holes on the landside slope.

Looking east at one of several rodent holes on landward slope.

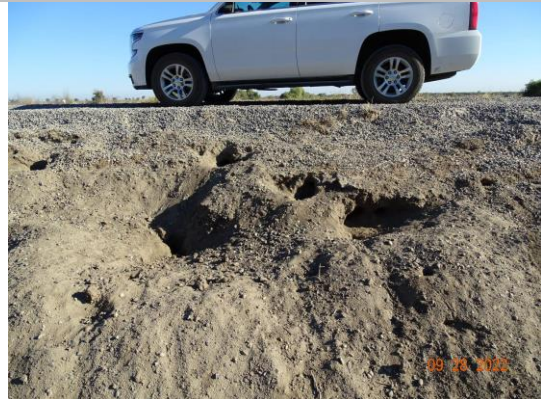
Photo 1 of 1 : SP_2024_NA0010_140_28_20240212_00010.jpg

LM Start	3.53	Rating **	U	Issue No.	28
LM End	3.59	Issue Type +	Ma	Location *	LS
Category	Earthen Levee			GPS Latitude/Longitude	
				Start	End
Item	Animal Control			36.768886°	36.768531°
				-120.237154°	-120.236226°
DWR ID	DWR_NA0010_24_f_2019_28				
Comment Code					
A3 : No rodents visible, but rodent burrows visible; need to backfill and compact or grout burrows.					
Inspector Comment

View of rodent burrows in the landside slope. (Fall 2022)

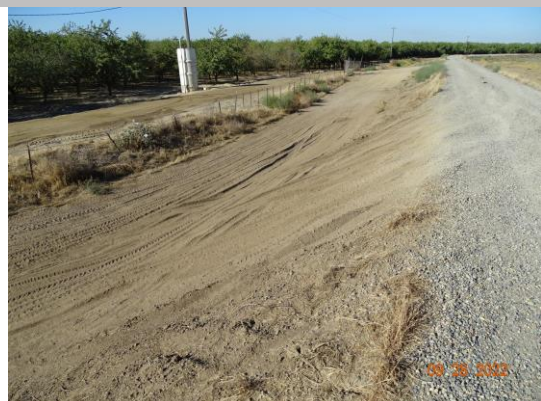
Photo 1 of 1 : SP_2024_NA0010_140_37_20240212_00013.jpg

LM Start	3.84	Rating **	A/W	Issue No.	37
LM End	3.84	Issue Type +	Ma	Location *	LS
Category	Earthen Levee			GPS Latitude/Longitude	
				Start	End
Item	Erosion / Vehicle Traffic			36.768024°	36.768024°
				-120.231896°	-120.231896°
DWR ID	DWR_NA0010_24_f_2022_37				
Comment Code					
E6 : Repair the levee slope damaged by vehicle traffic and prevent access where possible.					
Inspector Comment

View of the vehicle paths on the landside slope. (Fall 2022)

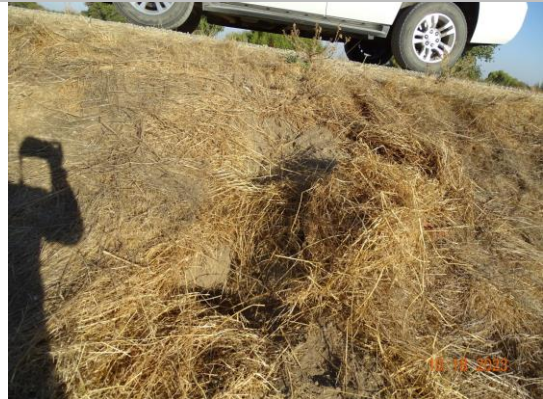
Photo 1 of 1 : SP_2024_NA0010_140_33_20240212_00012.jpg

LM Start	4.01	Rating **	M	Issue No.	33
LM End	4.01	Issue Type +	Ma	Location *	LS
Category	Earthen Levee			GPS Latitude/Longitude	
				Start	End
Item	Animal Control			36.768686°	36.768686°
				-120.229036°	-120.229036°
DWR ID	DWR_NA0010_24_f_2023_33				
Comment Code					
A3 : No rodents visible, but rodent burrows visible; need to backfill and compact or grout burrows.					
Inspector Comment

View of rodent burrows on the landside slope. (Fall 2023)

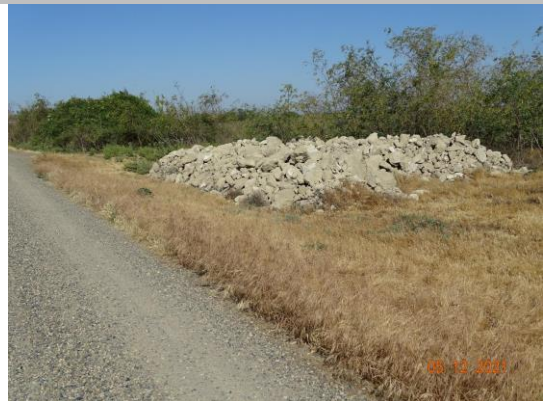
Photo 1 of 1 : SP_2024_NA0010_140_25_20240212_00009.jpg

LM Start	5.40	Rating **	M	Issue No.	25
LM End	5.40	Issue Type +	En	Location *	WS
Category	Earthen Levee			GPS Latitude/Longitude	
				Start	End
Item	Encroachments			36.782397°	36.782397°
				-120.222815°	-120.222815°
DWR ID	DWR_NA0010_24_s_2021_25				
Comment Code					
MA : Material					
Inspector Comment					
Rocks are stockpiled near the waterside toe.

Stockpile of rock kept at the waterside toe and river channel. (Spring 2021)

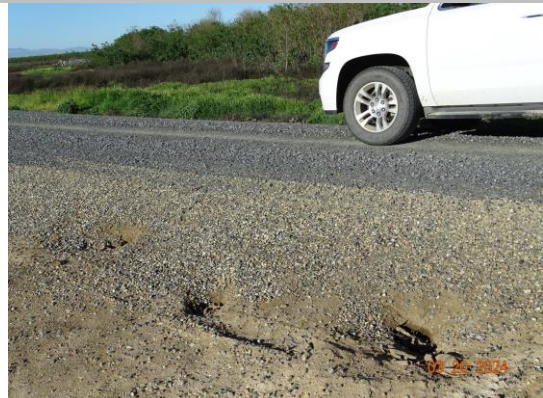
Photo 1 of 1 : SP_2024_NA0010_140_20_20240327_00029.jpg

LM Start	5.66	Rating **	M	Issue No.	20
LM End	5.66	Issue Type +	Ma	Location *	LS
Category	Earthen Levee			GPS Latitude/Longitude	
				Start	End
Item	Animal Control			36.784215°	36.784215°
				-120.218882°	-120.218882°
DWR ID	DWR_NA0010_24_f_2020_20				
Comment Code					
A3 : No rodents visible, but rodent burrows visible; need to backfill and compact or grout burrows.					
Inspector Comment

View of rodent holes at the landside toe. (Spring 2024)

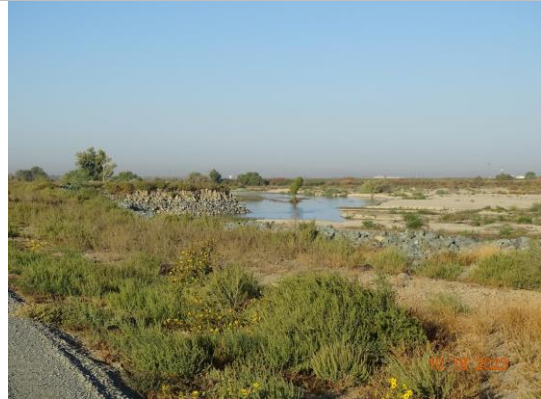
Photo 1 of 1 : SP_2024_NA0010_140_32_20240212_00011.jpg

LM Start	5.99	Rating **	A/W	Issue No.	32
LM End	6.10	Issue Type +	Ma	Location *	WS
Category	Earthen Levee			GPS Latitude/Longitude	
				Start	End
Item	Riprap Revetments			36.787422°	36.787874°
				-120.215689°	-120.213838°
DWR ID	DWR_NA0010_24_f_2023_32				
Comment Code					
RR : Riprap Revetments					
Inspector Comment

View of revetment placed on the waterside berm. (Fall 2023)

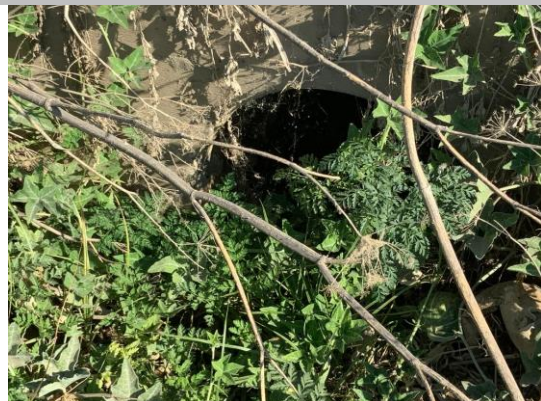
Photo 1 of 1 : UCIP_SP_2024_73634_102808.jpg

Comment Code					
Inspector Comment					
DS_ID:19956 FS_ID:73634 EP_NO: N/A Repair Type: Non-Urgent EVAL Issue: 11, Maintenance Compliance Issue Crossing Status: Found UCIP Comments: 07/20/2021 The record has been upgraded from No Action Needed to Non-Urgent. Limited inspection due to some vegetation covering LS pipe inlet, recommend removal. No permit has been identified authorizing pipe. Levee prism appears less than 3 feet in height. The UCIP inspection was completed with GEI staff, P. Espinoza. (H. Dunn – GEI) FIELD_STRUCT_DESC: 24-inch corrugated metal gravity drainage pipe (CMP) through the levee, 5.0 feet below the crown. Flap gate on the waterside (WS) end. Concrete headwall on the landside (LS) end. Concrete U-shaped headwall on the WS end. [Additional Reference(s): DWR Levee Log, 2002, (HLM 6.09). DWR As-Built Drawing No. 65-30, 27 April 1965, Sheet 12, STA 331+25]. FS Date: 7/20/2021

LS view: Closeup of pipe inlet at toe covered by vegetation.

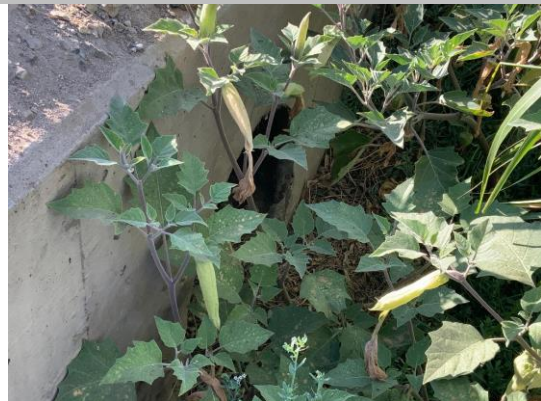
Photo 1 of 1 : UCIP_SP_2024_73635_102814.jpg

Comment Code					
Inspector Comment					
DS_ID:19957 FS_ID:73635 EP_NO: N/A Repair Type: Non-Urgent EVAL Issue: 11, Maintenance Compliance Issue Crossing Status: Found UCIP Comments: 07/20/2021 The record remains Non-Urgent. Limited inspection due to some vegetation covering LS pipe inlet, recommend removal. No permit was found authorizing this encroachment. The levee prism appears to be less than 3 feet. The UCIP inspection was completed with GEI staff, P. Espinoza. (H. Dunn – GEI) 7/20/2016 same as previous inspection. Crossing has been downgraded from Urgent to Non-Urgent PVC does not prevent WS flap gate from closing. (O. Magana - DWR UCIP)4/08/2014 Unauthorized PVC pipe through existig crossing. PVC distorted inside--Need to contact owner to correct issue. If crossing was allowed need to contact owner for permit number issue for crossing variance. (O. Magana - DWR UCIP) FIELD_STRUCT_DESC: 24-inch corrugated metal gravity drainage pipe (CMP) through the levee, 3.6 feet below the crown. Flap gate on the waterside (WS) end. Concrete headwall on the landside (LS) end. Concrete U-shaped headwall on the WS end. [Additional Reference(s): DWR Levee Log, 2002, (HLM 6.72). DWR As-Built Drawing No. 65-30, 27 April 1965, Sheet 13, STA 364+00]. FS Date: 7/20/2021

LS view: Closeup of pipe inlet at toe with vegetation overgrowth.

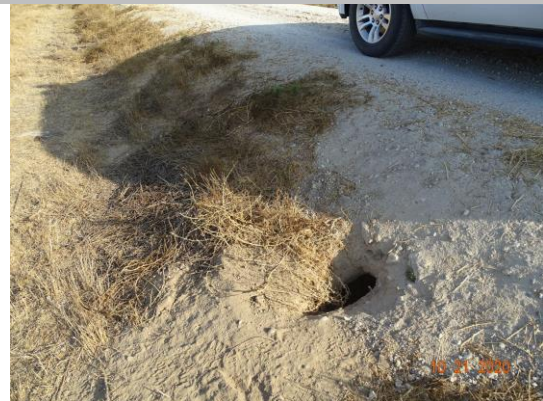
Photo 1 of 1 : SP_2024_NA0010_140_14_20240212_00005.jpg

LM Start	6.86	Rating **	M	Issue No.	14
LM End	6.86	Issue Type +	Ma	Location *	LS
Category	Earthen Levee			GPS Latitude/Longitude	
				Start	End
Item	Animal Control			36.784716°	36.784716°
				-120.204043°	-120.204043°
DWR ID	DWR_NA0010_24_f_2020_14				
Comment Code					
A3 : No rodents visible, but rodent burrows visible; need to backfill and compact or grout burrows.					
Inspector Comment

Rodent burrow on the landside slope. (Fall 2020)

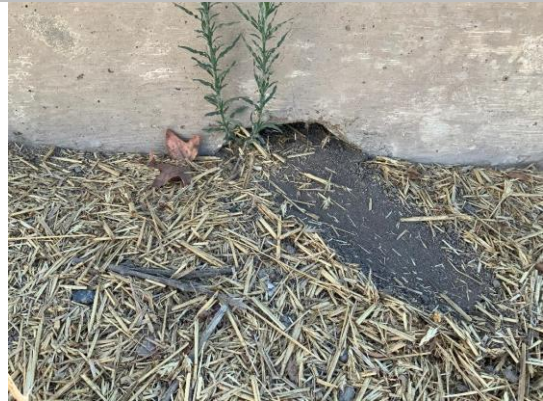
Photo 1 of 2 : UCIP_SP_2024_73636_102830.jpg

Comment Code						
Inspector Comment						
DS_ID:19958 FS_ID:73636 EP_NO: N/A Repair Type: Non-Urgent EVAL Issue: 11, Maintenance Compliance Issue Crossing Status: Found UCIP Comments: 07/20/2021 The record has been upgraded from No Action Needed to Non-Urgent. Limited inspection due to LS pipe inlet covered by sediment and WS flapgate covered by vegetation debris, recommend clearing out both sides. Levee prism appears to be less than 3 feet in height. The UCIP inspection was completed with GEI staff, P. Espinoza. (H. Dunn – GEI) FIELD_STRUCT_DESC: 12-inch corrugated metal gravity drainage pipe (CMP) through the levee, 2.5 feet below the crown. Flap gate on the waterside (WS) end. Concrete headwall on each end. [Additional Reference(s): DWR Levee Log, 2002, (HLM 7.63). DWR As-Built Drawing No. 65-30, 27 April 1965, Sheet 14, STA 412+70]. FS Date: 7/20/2021

LS view: Closeup of pipe inlet buried with sediment.

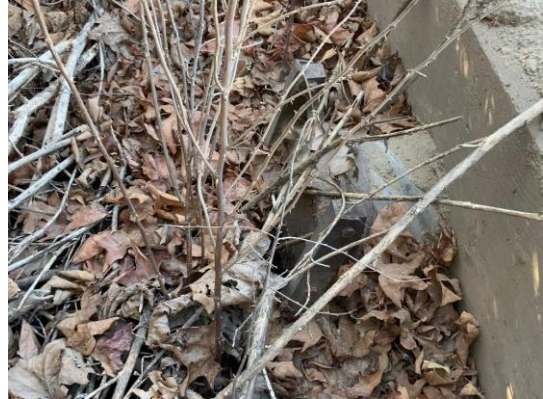
Photo 2 of 2 : UCIP_SP_2024_73636_102832.jpg

WS view: Closeup of flapgate at toe with vegetation debris.

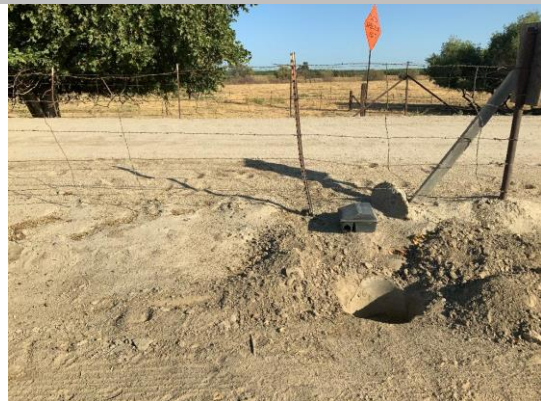
Photo 1 of 2 : UCIP_SP_2024_73638_102864.jpg

DS_ID:19960
 FS_ID:73638
 EP_NO: N/A
 Repair Type: Non-Urgent
 EVAL Issue: 11, Maintenance Compliance Issue
 Crossing Status: Found
 UCIP Comments: 07/20/2021 The record remains Non-Urgent. WS outlet filled with sediment, recommend cleaning out. LS pipe inlet not found, likely buried under dirt, recommend removal. No permit was found authorizing this encroachment. CVFPB will need to review crossing to determine owner. Levee prism appears to be less than 3 feet in height. The UCIP inspection was completed with GEI staff, P. Espinoza. (H. Dunn – GEI) 04/08/2014 Barbed wire along levee shoulder--no access. Need to confirm crossing size and condition of crossing. (O. Magana - DWR UCIP)
 FIELD_STRUCT_DESC: 12-inch reinforced concrete gravity drainage pipe (RCP) through the levee, 3.0 feet below the crown. Flap gate on the waterside (WS) end. Concrete headwall on the WS end. [Additional Reference(s): DWR Levee Log, 2002, (HLM 8.33). USACE San Joaquin O&M Manual, Unit No. 601, Part No. 1, 1967, Amended in 1978, Revised 20 June 1985, (HLM 8.32). DWR As-Built Specification No. 65-30, Sheet No. 14, 27 April 1965, (HLM 8.32)].

LS view: Slope from toe, no pipe visible.

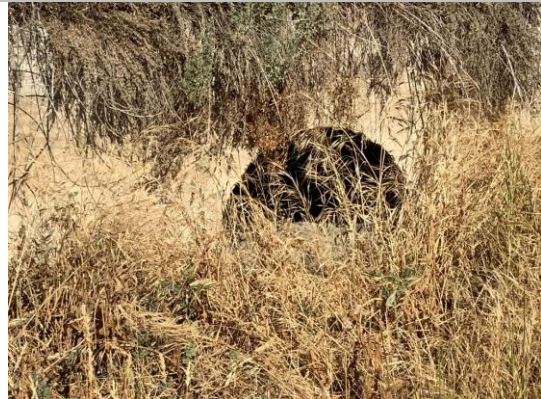
Photo 1 of 1 : UCIP_SP_2024_77879_100683.jpg

Comment Code						
Inspector Comment						
DS_ID:19965 FS_ID:77879 EP_NO: N/A Repair Type: Urgent EVAL Issue: 1, Pipe Integrity Crossing Status: Found UCIP Comments: 12/14/2022 Record updated from Non-Urgent to Urgent. DMP internal video inspection has found pipe integrity issues. LOF of crossing is between 5 and 6. Crossing will be monitored until funding becomes available to address the issues. (O.Yakimov - DWR UCIP) 06/8/2021 The record remains Non-Urgent. Landside (LS) pipe inlet has some vegetation and sediment buildup, recommend cleaning out. The UCIP inspection was completed with GEI staff, P. Espinoza. (H. Dunn - GEI) 05/01/2014 Dense vegetation limits the inspectors visibility to identify signs of pipe failure (leaks) along the slope. Recommend removing vegetation along pipe alignment to conduct proper inspection of structure. Sediment buildup in pipe visible from landward side-- recommend clearing. (O. Magana - DWR UCIP) FIELD_STRUCT_DESC: 24-inch corrugated metal gravity drainage pipe (CMP) through the levee, 10.0 feet below the crown. Flap gate on the waterside (WS) end. Concrete headwalls on both ends. [Additional Reference(s): DWR Levee Log, 2002, (HLM 0.01). USACE San Joaquin O&M Manual, Unit No. 601, Part No. 1, 1967, Amended in 1978, Revised 20 June 1985, (HLM 0.02). DWR As-Built Specification No. 59-01, Sheet No. 49, 10 December 1958, (HLM 0.02)]. FS Date: 6/8/2021 3:12:00 PM

LS view: Close up of pipe inlet at toe.

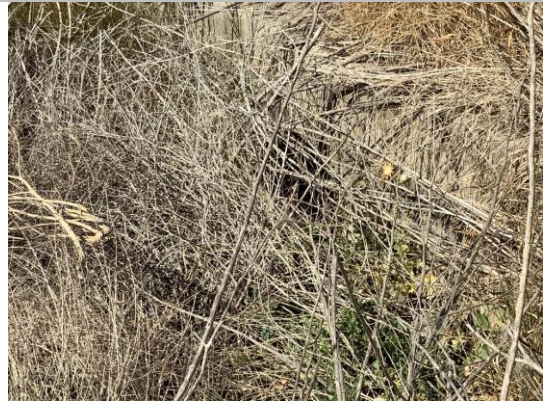
Photo 1 of 1 : UCIP_SP_2024_77880_100701.jpg

Comment Code						
Inspector Comment						
DS_ID:19966 FS_ID:77880 EP_NO: N/A Repair Type: Urgent EVAL Issue: 1, Pipe Integrity Crossing Status: Found UCIP Comments: 12/14/2022 Record updated from Non-Urgent to Urgent. DMP internal video inspection has found pipe integrity issues. LOF of crossing is between 5 and 6. Crossing will be monitored until funding becomes available to address the issues. (O.Yakimov - DWR UCIP) 06/8/2021 The record remains Non-Urgent. Dense LS vegetation over pipe inlet and headwall, recommend removal. The UCIP inspection was completed with GEI staff, P. Espinoza. (H. Dunn – GEI) 05/01/2014 Dense vegetation limits the inspectors visibility to identify signs of pipe failure (leaks) along the slope. Recommend removing vegetation along pipe alignment to conduct proper inspection of structure. (O. Magana - DWR UCIP) FIELD_STRUCT_DESC: 24-inch corrugated metal gravity drainage pipe (CMP) through the levee, 11.6 feet below the crown. Flap gate on the waterside (WS) end. Concrete headwalls on both ends. [Additional Reference(s): DWR Levee Log, 2002, (HLM 0.36). USACE San Joaquin O&M Manual, Unit No. 601, Part No. 1, 1967, Amended in 1978, Revised 20 June 1985, (HLM 0.35). DWR As-Built Specification No. 59-01, Sheet No. 49, 10 December 1958, (HLM 0.35)]. FS Date: 6/8/2021 3:12:19 PM

LS view: Headwall barely visible at toe due to dense vegetation.

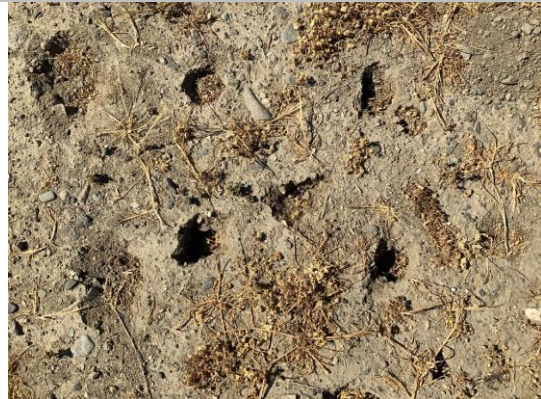
Photo 1 of 2 : UCIP_SP_2024_77882_100718.jpg

Comment Code						
Inspector Comment						
DS_ID:19968 FS_ID:77882 EP_NO: N/A Repair Type: Urgent EVAL Issue: 1, Pipe Integrity Crossing Status: Found UCIP Comments: 12/14/2022 Record updated from Non-Urgent to Urgent. DMP internal video inspection has found pipe integrity issues. LOF of crossing is between 5 and 6. Crossing will be monitored until funding becomes available to address the issues. (O.Yakimov - DWR UCIP) 06/8/2021 The record remains Non-Urgent. Dense LS vegetation over pipe inlet, recommend removal. Lots of small burrow holes all along the crown and along the sides, recommend filling in. The UCIP inspection was completed with GEI staff, P. Espinoza. (H. Dunn – GEI) 05/01/2014 Dense vegetation limits the inspectors visibility to identify signs of pipe failure (leaks) along the slope. Recommend removing vegetation along pipe alignment to conduct proper inspection of structure. (O. Magana - DWR UCIP) FIELD_STRUCT_DESC: 24-inch corrugated metal gravity drainage pipe (CMP) through the levee, 11.4 feet below the crown. Flap gate on the waterside (WS) end. Concrete headwalls on both ends. [Additional Reference(s): DWR Levee Log, 2002, (HLM 0.97). USACE San Joaquin O&M Manual, Unit No. 601, Part No. 1, 1967, Amended in 1978, Revised 20 June 1985, (HLM 0.97). DWR As-Built Specification No. 59-01, Sheet No. 49, 10 December 1958, (HLM 0.97)]. FS Date: 6/8/2021 3:13:09 PM

Crown: Small burrow holes along the crown, 1 of 2 photos.

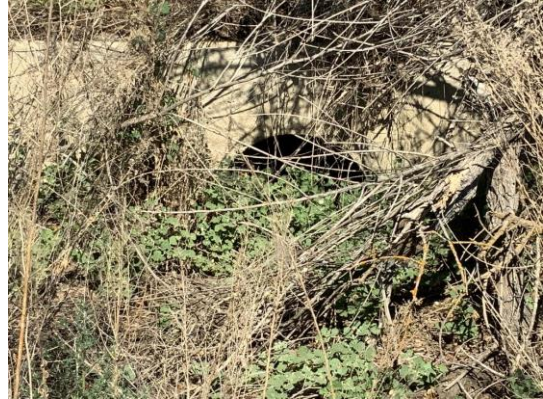
Photo 2 of 2 : UCIP_SP_2024_77882_100714.jpg

LS view: Close up of pipe inlet covered with vegetation.

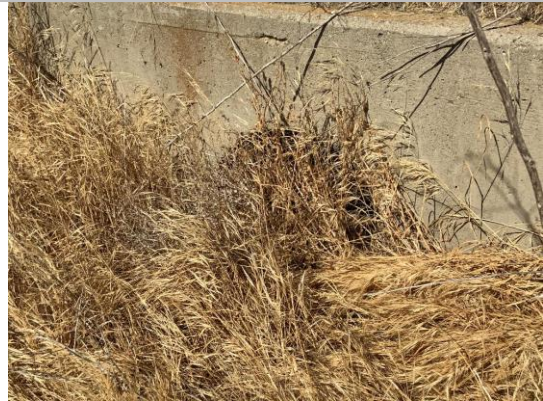
Photo 1 of 1 : UCIP_SP_2024_77390_100732.jpg

DS_ID:19969
FS_ID:77390
EP_NO: N/A
Repair Type: Non-Urgent
EVAL Issue: 11, Maintenance Compliance Issue
Crossing Status: Found
UCIP Comments: 06/8/2021 The record remains Non-Urgent. Levee prism appears to be around or slightly less than 3 feet. Dense vegetation on LS pipe inlet, recommend removal. The UCIP inspection was completed with GEI staff, P. Espinoza. (H. Dunn – GEI)

LS view: Close up of pipe inlet at toe covered with vegetation.

05/01/2014 Dense vegetation limits the inspectors visibility to identify signs of pipe failure (leaks) along the slope. Recommend removing vegetation along pipe alignment to conduct proper inspection of structure. (O. Magana - DWR UCIP)

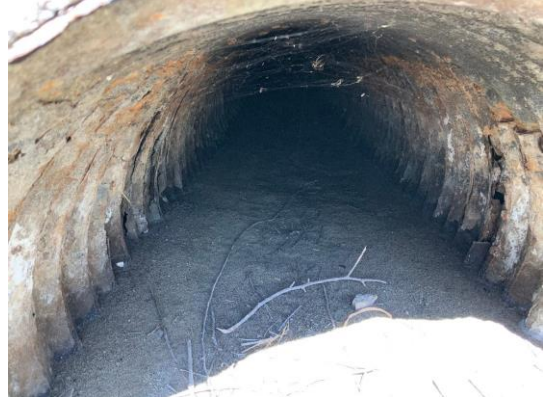
Photo 1 of 3 : UCIP_SP_2024_77391_100738.jpg

Comment Code						
Inspector Comment						
DS_ID:19970 FS_ID:77391 EP_NO: N/A Repair Type: Urgent EVAL Issue: 1, Pipe Integrity Crossing Status: Found UCIP Comments: 06/8/2021 Record has been upgraded from Non-Urgent to Urgent. External inspection in the field has found pipe integrity issues. WS pipe end is rusted with multiple large deteriorated holes under and around the flapgate. Rusting and peeling of metal and liner inside the LS pipe inlet. Also sediment buildup inside LS inlet, recommend cleaning out and recommend monitoring crossing until funding becomes available to address the issues. The UCIP inspection was completed with GEI staff, P. Espinoza. (H. Dunn – GEI)05/01/2014 Dense vegetation limits the inspectors visibility to identify signs of pipe failure (leaks) along the slope. Recommend removing vegetation along pipe alignment to conduct proper inspection of structure. Sediment buildup in pipe visible on landward side--recommend clearing. (O. Magana - DWR UCIP) FIELD_STRUCT_DESC: 24-inch corrugated metal gravity drainage pipe (CMP) through the levee, 11.2 feet below the crown. Flap gate on the waterside (WS) end. Concrete headwalls on both ends. [Additional Reference(s): DWR Levee Log, 2002, (HLM 2.45). USACE San Joaquin O&M Manual, Unit No. 601, Part No. 1, 1967, Amended in 1978, Revised 20 June 1985, (HLM 2.45). DWR As-Built Specification No. 59-01, Sheet No. 50, 10 December 1958, (HLM 2.45)]. FS Date: 6/8/2021

LS view: Inside of pipe inlet. Sediment buildup and rusted and peeling walls.

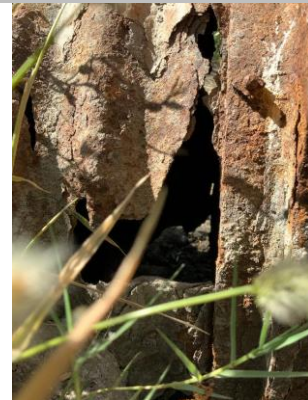
Photo 2 of 3 : UCIP_SP_2024_77391_100740.jpg

WS view: Deterioration of flapgate, 1 of 4 photos.
