**Flood Control Project Maintenance
Levee Inspections**

Maintenance Issue Types Only, Levee Inspection Report By Mile - Fall 2014

Lower San Joaquin Levee District

Waterway	Bank	Unit Miles	Inspection Start/End	Inspector
Unit No. 01 San Joaquin River	Right	22.52	11/03/2014 11/06/2014	Richard Willoughby

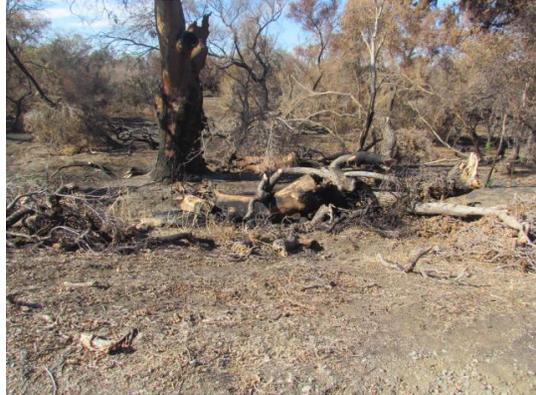
Photo 2 of 2 : FA_2014_NA0010_118_98_20141110_00021.jpg

LM Start	0.07	Rating **	M	Issue No.	98 (cont)
LM End	0.07	Issue Type +	Ma	Location *	WS
Category	Earthen Levee			GPS Latitude/Longitude	
				Start	End
Item	Encroachments			37.348157 °	37.348157 °
				-120.959658 °	-120.959658 °
DWR ID	DWR_NA0010_01_f_2014_98				
Action/Comments					
Tree or limb Inspector Comments: Downed tree limbs due to fire along levee slope.

Looking southwest at tree limbs on waterwater toe.

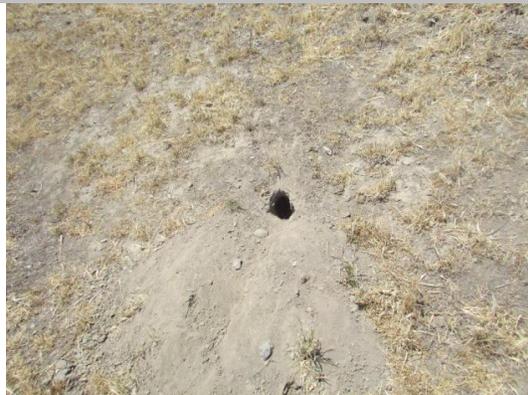
Photo 1 of 1 : FA_2014_NA0010_118_1_20141103_00001.jpg

LM Start	0.24	Rating **	M	Issue No.	1
LM End	0.41	Issue Type +	Ma	Location *	LS
Category	Earthen Levee		GPS Latitude/Longitude		
			Start	End	
Item	Animal Control		37.346152 °	37.343935 °	
			-120.961402 °	-120.962536 °	
DWR ID	DWR_NA0010_01_s_2012_1				
Action/Comments					
Exterminate rodents and backfill and compact or grout burrows. Inspector Comments: Typical view of several rodent holes on landward slope.

Looking at typical rodent holes on landward slope.

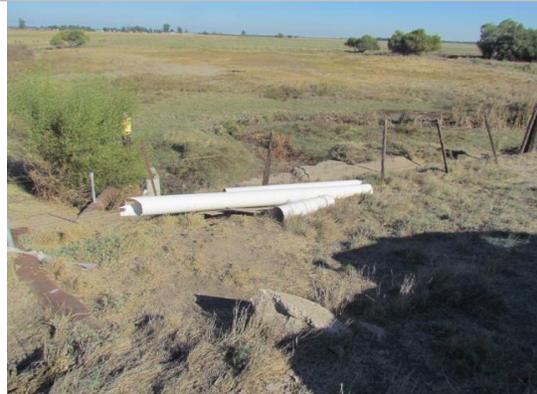
Photo 1 of 1 : FA_2014_NA0010_118_100_20141110_00024.jpg

LM Start	4.16	Rating **	M	Issue No.	100
LM End	4.16	Issue Type +	Ma	Location *	N/A
Category	Earthen Levee		GPS Latitude/Longitude		
			Start	End	
Item	Encroachments		37.309049 °	37.309049 °	
			-120.924421 °	-120.924421 °	
DWR ID	DWR_NA0010_01_f_2014_100				
Action/Comments					
Garbage Inspector Comments: Old PVC pipes left on landward slope.

Looking east at old pvc pipes on landward slope.

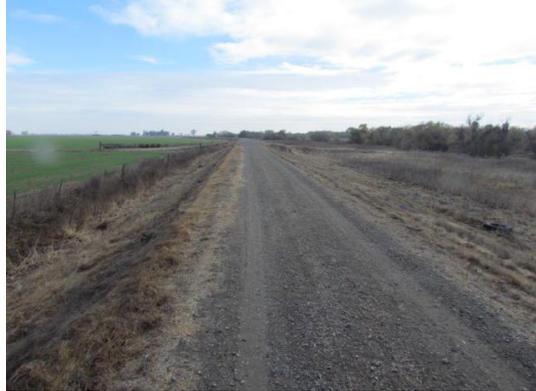
Photo 2 of 3 : FA_2014_NA0010_118_117_20141103_00019.jpg

LM Start	9.21	Rating **	A/W	Issue No.	117 (cont)
LM End	10.76	Issue Type +	Ma	Location *	CR
Category	Earthen Levee			GPS Latitude/Longitude	
				Start	End
Item	Crown Surface / Depressions / Rutting			37.296145 °	37.293077 °
				-120.848588 °	-120.839170 °
DWR ID	DWR_NA0010_01_s_2012_117				
Action/Comments					
Add appropriate material and re-grade the levee to bring the crown above the design elevation. Inspector Comments: Control vegetation on levee crown.

Looking south at levee crown. (Fall 2013)

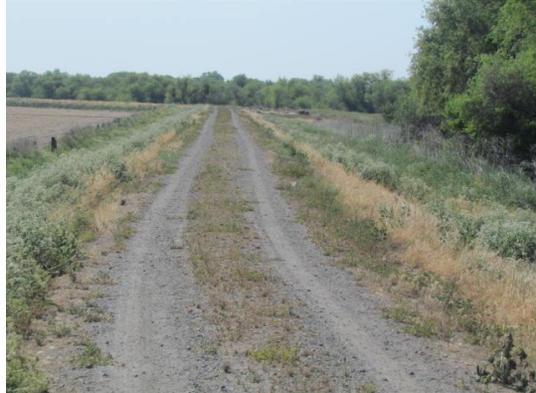
Photo 3 of 3 : FA_2014_NA0010_118_117_20141103_00020.jpg

LM Start	9.21	Rating **	A/W	Issue No.	117 (cont)
LM End	10.76	Issue Type +	Ma	Location *	CR

Looking south at vegetation on levee crown. (Spring 2013)

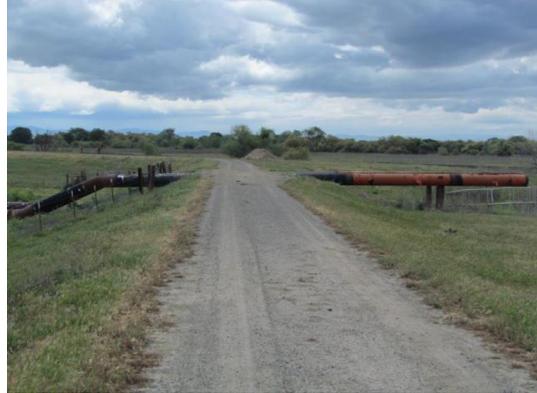
Photo 1 of 1 : FA_2014_NA0010_118_8_20141103_00004.jpg

LM Start	19.33	Rating **	M	Issue No.	8
LM End	19.33	Issue Type +	Ma	Location *	CR
Category	Earthen Levee		GPS Latitude/Longitude		
			Start	End	
Item	Encroachments		37.200923 °	37.200923 °	
			-120.756987 °	-120.756987 °	
DWR ID	DWR_NA0010_01_s_2012_8				
Action/Comments					
Pipe Inspector Comments: Farmer installed a pipe across levee crown, landside and waterside slopes. Ramp is not according to standards.

Looking south at pipe across levee crown.

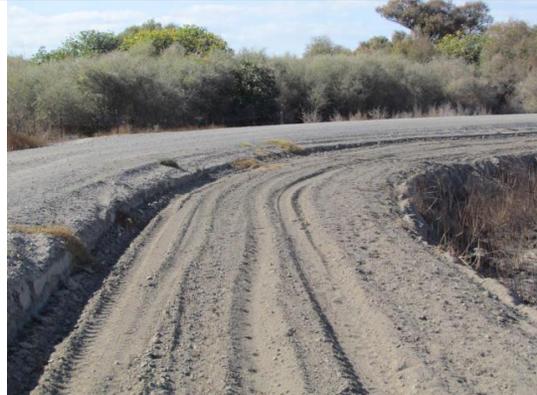
Photo 1 of 2 : FA_2014_NA0010_118_20_20141103_00007.jpg

LM Start	20.28	Rating **	M	Issue No.	20
LM End	22.02	Issue Type +	Ma	Location *	LS
Category	Earthen Levee		GPS Latitude/Longitude		
			Start	End	
Item	Encroachments		37.193426 °	37.172663 °	
			-120.760419 °	-120.754894 °	
DWR ID	DWR_NA0010_01_f_2012_20				
Action/Comments					
Agricultural tilling Inspector Comments: Farmer cutting into landside toe and slope.

Looking east at farmer discing into landside slope.

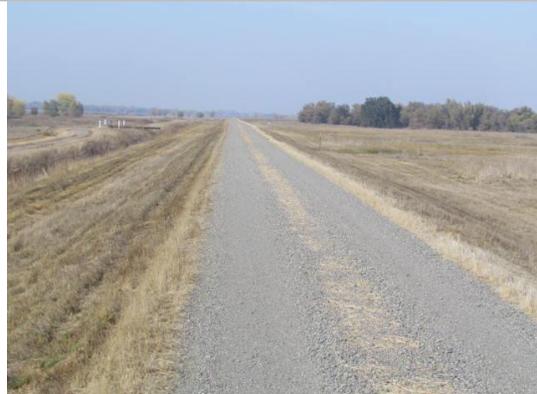
Photo 1 of 2 : FA_2014_NA0010_119_9_20141110_00007.jpg

LM Start	0.00	Rating **	A/W	Issue No.	9
LM End	5.30	Issue Type +	Ma	Location *	CR
Category	Earthen Levee		GPS Latitude/Longitude		
			Start	End	
Item	Vegetation		37.296229 °	37.261893 °	
			-120.880732 °	-120.832390 °	
DWR ID	DWR_NA0010_02A_s_2014_9				
Action/Comments					
Remove the wild growth other than native grasses from the levee slopes. Inspector Comments: Control vegetation on levee crown.

Looking north at levee crown complies with standards.

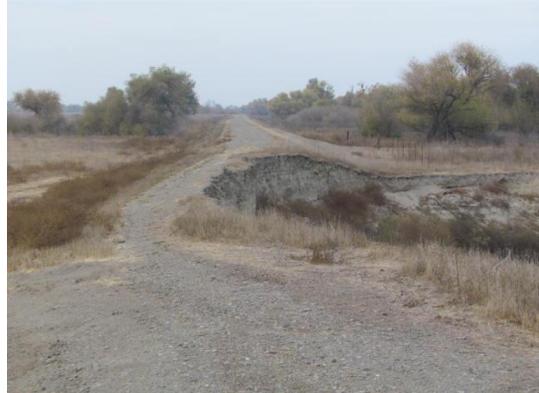
Photo 2 of 3 : FA_2014_NA0010_119_5_20141103_00004.jpg

LM Start	0.77	Rating **	U	Issue No.	5 (cont)
LM End	0.77	Issue Type +	Ma	Location *	WS

Looking north at large erosion on waterward slope. (Fall 2013)

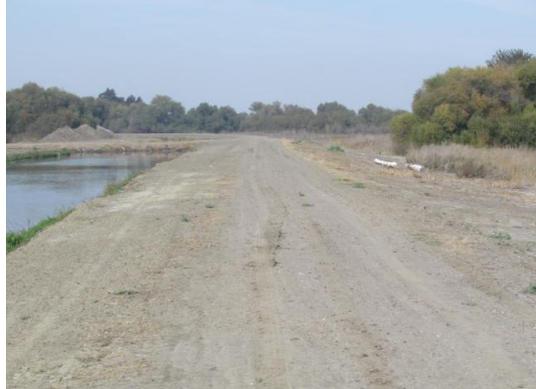
Photo 1 of 2 : FA_2014_NA0010_120_3_20141110_00007.jpg

LM Start	7.87	Rating **	A/W	Issue No.	3
LM End	13.45	Issue Type +	Ma	Location *	LS
Category	Earthen Levee		GPS Latitude/Longitude		
			Start	End	
Item	Vegetation		37.231279 °	37.176608 °	
			-120.811852 °	-120.762619 °	
DWR ID	DWR_NA0010_02B_f_2014_3				
Action/Comments					
Keep the crown roadway free of vegetation. Inspector Comments: Control vegetation growth on levee crown.

Looking north at levee crown complies with standards. (Fall 2014)

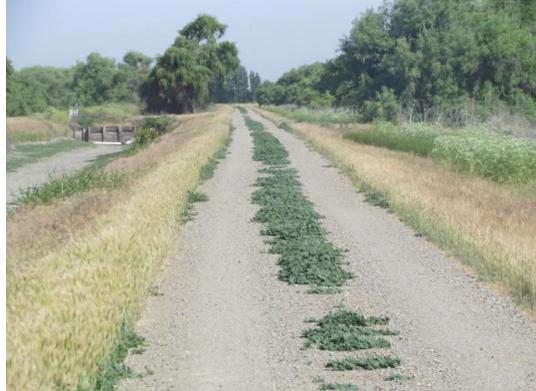
Photo 2 of 2 : FA_2014_NA0010_120_3_20141103_00001.jpg

LM Start	7.87	Rating **	A/W	Issue No.	3 (cont)
LM End	13.45	Issue Type +	Ma	Location *	LS

Looking north at vegetation on levee crown. (Spring 2014)

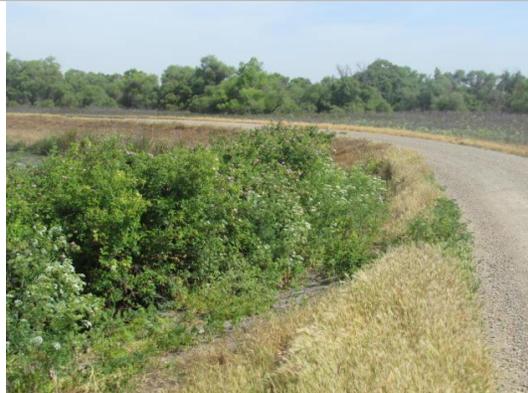
Photo 1 of 1 : FA_2014_NA0010_120_5_20141103_00002.jpg

LM Start	12.10	Rating **	A/W	Issue No.	5
LM End	12.10	Issue Type +	Ma	Location *	LS
Category	Earthen Levee		GPS Latitude/Longitude		
			Start	End	
Item	Vegetation		37.193504 °	37.193504 °	
			-120.763859 °	-120.763859 °	
DWR ID	DWR_NA0010_02B_s_2012_5				
Action/Comments					
Remove the wild growth other than native grasses from the levee slopes. Inspector Comments: Remove wild roses on landside toe.

Looking north at wildroses on landward slope.

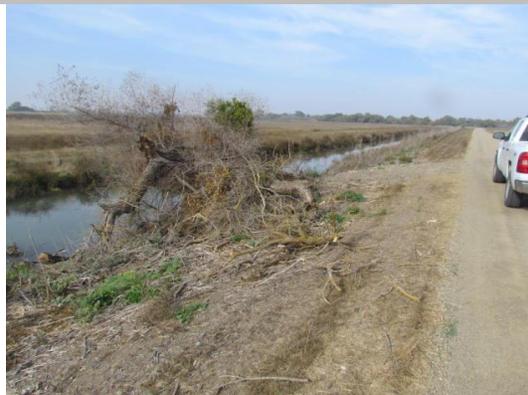
Photo 1 of 2 : FA_2014_NA0010_120_1_20141110_00009.jpg

LM Start	12.25	Rating **	M	Issue No.	1
LM End	12.25	Issue Type +	Ma	Location *	LS
Category	Earthen Levee		GPS Latitude/Longitude		
			Start	End	
Item	Encroachments		37.191500 °	37.191500 °	
			-120.764521 °	-120.764521 °	
DWR ID	DWR_NA0010_02B_f_2014_1				
Action/Comments					
Tree or limb Inspector Comments: Fallen tree limbs on landward slope.

Looking southwest at tree limb on waterward slope.

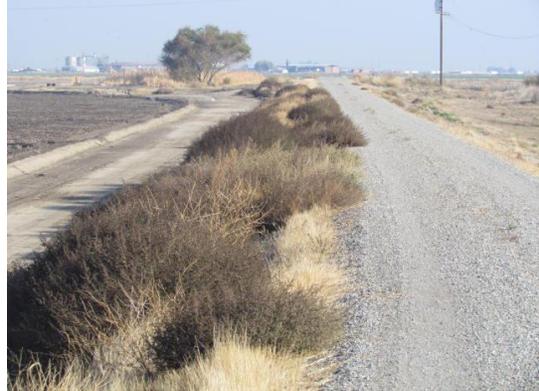
Photo 1 of 1 : FA_2014_NA0010_121_4_20141110_00001.jpg

LM Start	0.42	Rating **	M	Issue No.	4
LM End	2.11	Issue Type +	Ma	Location *	LS
Category	Earthen Levee		GPS Latitude/Longitude		
			Start	End	
Item	Vegetation		37.106450 °	37.088965 °	
			-120.586024 °	-120.566867 °	
DWR ID	DWR_NA0010_03_f_2014_4				
Action/Comments					
Control annual grass and weeds on the levee slopes and easements. Inspector Comments: Control tumble weeds on landward slope.

Looking north at tumble weeds on landward slope.

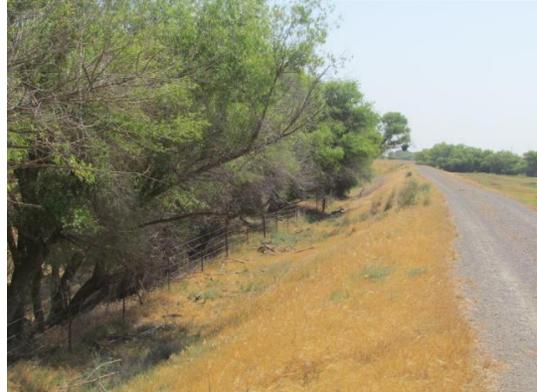
Photo 1 of 2 : FA_2014_NA0010_123_3_20141103_00002.jpg

LM Start	2.81	Rating **	A/W	Issue No.	3
LM End	2.86	Issue Type +	Ma	Location *	LS
Category	Earthen Levee		GPS Latitude/Longitude		
			Start	End	
Item	Trim / Thin Trees		37.256803 °	37.256835 °	
			-120.785407 °	-120.784528 °	
DWR ID	DWR_NA0010_05_s_2012_3				
Action/Comments					
Thin trees to allow visibility of the ground and room to flood fight.

Looking south at trimmed trees on landward slope and toe.

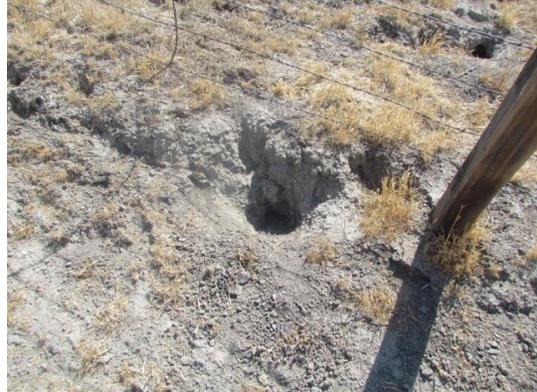
Photo 1 of 2 : FA_2014_NA0010_124_10_20141103_00010.jpg

LM Start	4.72	Rating **	M	Issue No.	10
LM End	4.72	Issue Type +	Ma	Location *	LS
Category	Earthen Levee		GPS Latitude/Longitude		
			Start	End	
Item	Animal Control		37.243540 °	37.243540 °	
			-120.760782 °	-120.760782 °	
DWR ID	DWR_NA0010_06_s_2012_10				
Action/Comments					
No rodents visible, but rodent burrows visible; need to backfill and compact or grout burrows. Inspector Comments: Rodent holes next to fence post on landward slope.

Looking at rodent hole along fence line on landward slope.

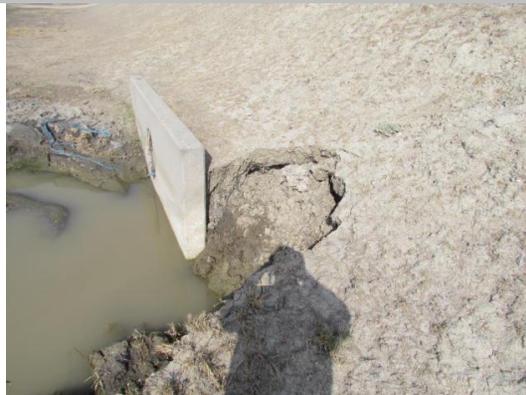
Photo 2 of 2 : FA_2014_NA0010_124_65_20141110_00016.jpg

LM Start	6.05	Rating **	U	Issue No.	65 (cont)
LM End	6.05	Issue Type +	Ma	Location *	LS
Category	Interior Drainage & Piping Systems			GPS Latitude/Longitude	
				Start	End
Item	Erosion Areas			37.236372 °	37.236372 °
				-120.739706 °	-120.739706 °
DWR ID	DWR_NA0010_06_f_2014_65				
Action/Comments					
Inspector Comments: Erosion on right side of drain structure headwall at landward toe.

Looking south erosion around headwall of drainage structure on landward toe.

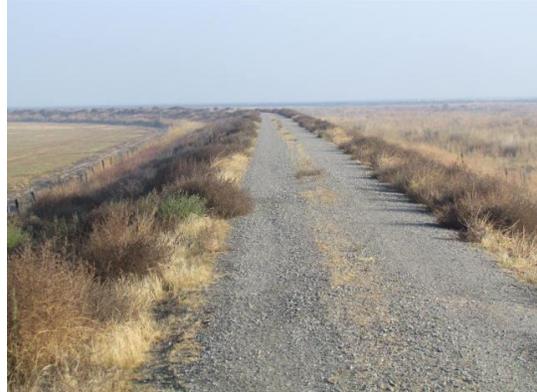
Photo 1 of 1 : FA_2014_NA0010_124_63_20141110_00018.jpg

LM Start	16.98	Rating **	M	Issue No.	63
LM End	19.32	Issue Type +	Ma	Location *	LS
Category	Earthen Levee		GPS Latitude/Longitude		
			Start	End	
Item	Vegetation		37.144129 °	37.113644 °	
			-120.602479 °	-120.588271 °	
DWR ID	DWR_NA0010_06_f_2014_63				
Action/Comments					
Remove the wild growth other than native grasses from the levee slopes. Inspector Comments: Control tumble weeds on landward and waterward slopes.

Looking north at tumble weeds on levee slopes.

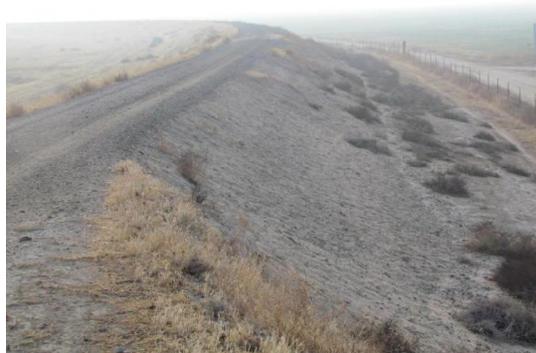
Photo 2 of 4 : FA_2014_NA0010_124_3_20141103_00004.jpg

LM Start	27.56	Rating **	M	Issue No.	3 (cont)
LM End	27.87	Issue Type +	Ma	Location *	LS

Looking south at livestock erosion on landward slope. (Fall 2013)

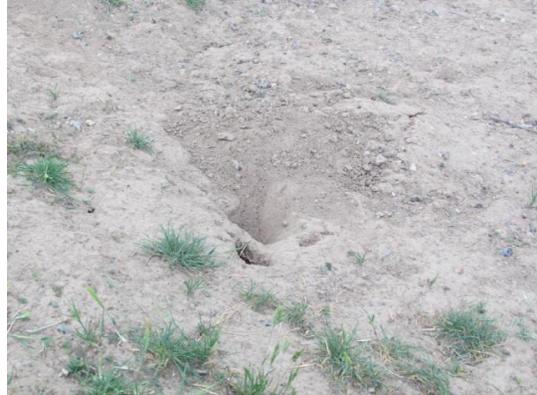
Photo 2 of 2 : FA_2014_NA0010_124_2_20141103_00002.jpg

LM Start	31.01	Rating **	M	Issue No.	2 (cont)
LM End	31.01	Issue Type +	Ma	Location *	LS
Category	Earthen Levee		GPS Latitude/Longitude		
			Start	End	
Item	Animal Control		37.017955 °	37.017955 °	
			-120.435017 °	-120.435017 °	
DWR ID	DWR_NA0010_06_s_2012_2				
Action/Comments					
Exterminate rodents and backfill and compact or grout burrows.

Looking at typical rodent hole on landside slope.

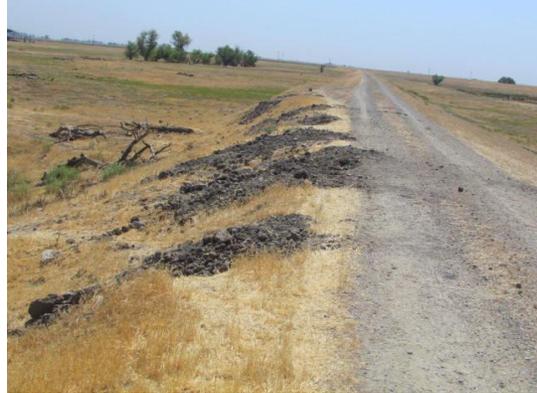
Photo 2 of 4 : FA_2014_NA0010_125_3_20141103_00004.jpg

LM Start	1.51	Rating **	M	Issue No.	3 (cont)
LM End	1.51	Issue Type +	Ma	Location *	LS
Category	Earthen Levee		GPS Latitude/Longitude		
			Start	End	
Item	Animal Control		37.263930 °	37.263930 °	
			-120.750680 °	-120.750680 °	
DWR ID	DWR_NA0010_07_s_2012_3				
Action/Comments					
Repair the levee slope damaged by livestock and prevent large animal access. Inspector Comments: Erosion on landward slope has been repaired by district. Landward toe erosion not repaired.

Looking south at landward slope.

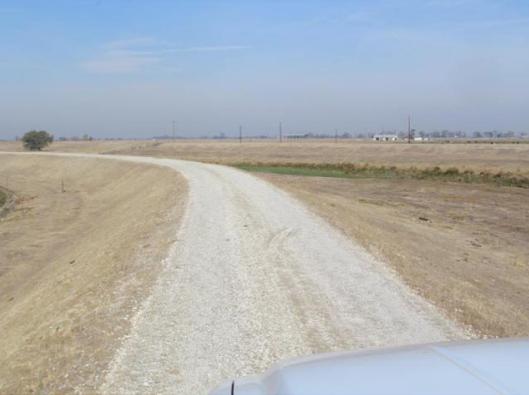
Photo 1 of 2 : FA_2014_NA0010_126_28_20141110_00012.jpg

LM Start	0.00	Rating **	A/W	Issue No.	28
LM End	2.22	Issue Type +	Ma	Location *	LS
Category	Earthen Levee		GPS Latitude/Longitude		
			Start	End	
Item	Vegetation		37.253178 °	37.256802 °	
			-120.768513 °	-120.740452 °	
DWR ID	DWR_NA0010_08_s_2012_28				
Action/Comments					
Keep the crown roadway free of vegetation.

Looking west at levee crown in complies with standards.

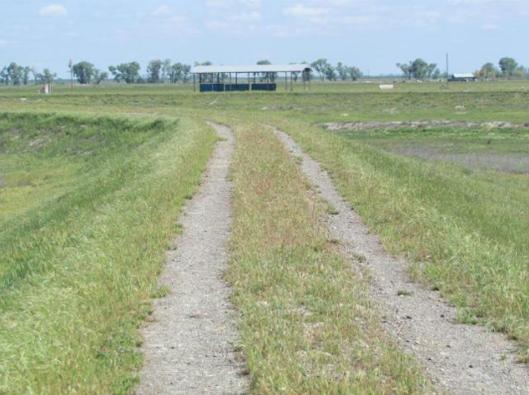
Photo 2 of 2 : FA_2014_NA0010_126_28_20141103_00008.jpg

LM Start	0.00	Rating **	A/W	Issue No.	28 (cont)
LM End	2.22	Issue Type +	Ma	Location *	LS

Looking west at vegetation on levee crown.

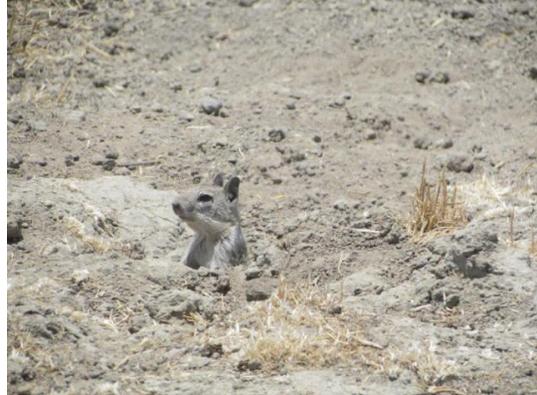
Photo 1 of 1 : FA_2014_NA0010_126_8_20141103_00007.jpg

LM Start	1.38	Rating **	M	Issue No.	8
LM End	1.38	Issue Type +	Ma	Location *	LS
Category	Earthen Levee		GPS Latitude/Longitude		
			Start	End	
Item	Animal Control		37.263175 °	37.263175 °	
			-120.752307 °	-120.752307 °	
DWR ID	DWR_NA0010_08_s_2013_8				
Action/Comments					
Exterminate rodents and backfill and compact or grout burrows.

Looking west at rodent holes on landward slope.

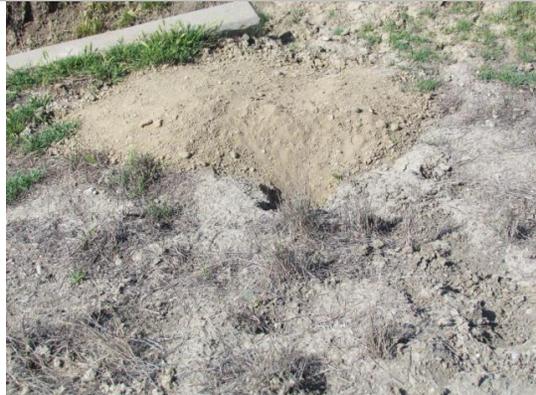
Photo 3 of 3 : FA_2014_NA0010_126_7_20141103_00006.jpg

LM Start	2.07	Rating **	M	Issue No.	7 (cont)
LM End	2.12	Issue Type +	Ma	Location *	LS
Category	Earthen Levee		GPS Latitude/Longitude		
			Start	End	
Item	Animal Control		37.258063 °	37.257688 °	
			-120.742460 °	-120.741573 °	
DWR ID	DWR_NA0010_08_s_2012_7				
Action/Comments					
Exterminate rodents and backfill and compact or grout burrows. Inspector Comments: Several rodent holes were noted on landside slope near drainage pipe.

Looking at typical rodent hole on landside slope near headwall.

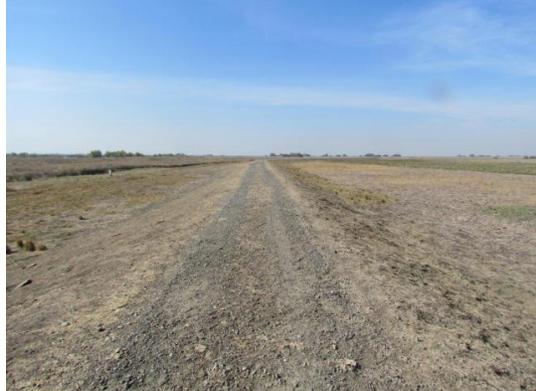
Photo 1 of 3 : FA_2014_NA0010_127_3_20141110_00001.jpg

LM Start	0.87	Rating **	A	Issue No.	3
LM End	0.87	Issue Type +	Ma	Location *	LS
Category	Earthen Levee		GPS Latitude/Longitude		
			Start	End	
Item	Vegetation		37.220039 °	37.220039 °	
			-120.698444 °	-120.698444 °	
DWR ID	DWR_NA0010_09_f_2014_3				
Action/Comments					
Control annual grass and weeds on the levee slopes and easements. Inspector Comments: Levee is well maintained.

Looking south at levee crown in compliance with standards.

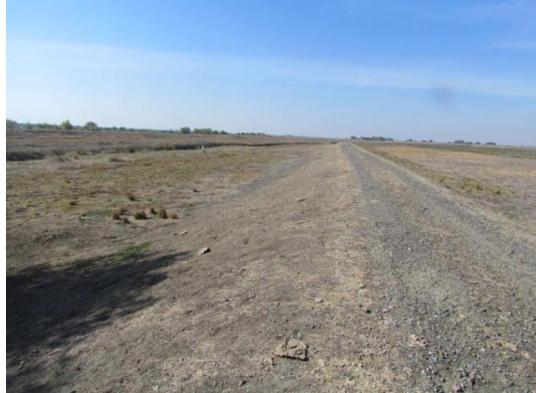
Photo 2 of 3 : FA_2014_NA0010_127_3_20141110_00002.jpg

Looking south at waterward slope in compliance with standards.

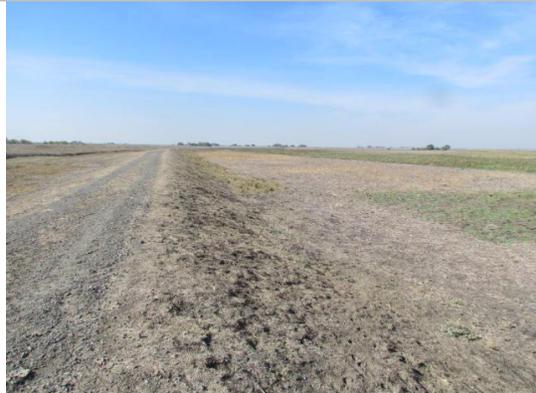
Photo 3 of 3 : FA_2014_NA0010_127_3_20141110_00003.jpg

Looking south at landward slope in compliance with standards.

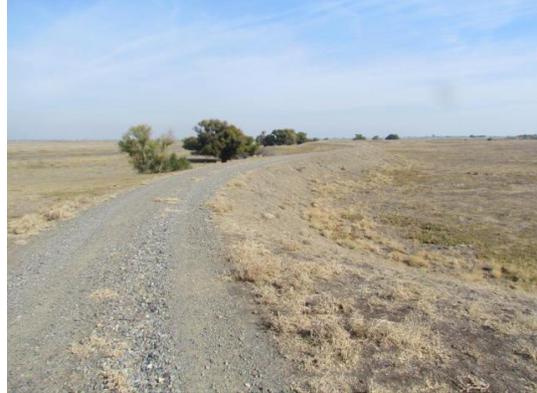
Photo 1 of 2 : FA_2014_NA0010_128_2_20141110_00001.jpg

LM Start	0.00	Rating **	A	Issue No.	2
LM End	0.82	Issue Type +	Ma	Location *	LS
Category	Earthen Levee		GPS Latitude/Longitude		
			Start	End	
Item	Vegetation		37.217971 °	37.217971 °	
			-120.711415 °	-120.711415 °	
DWR ID	DWR_NA0010_10_f_2014_2				
Action/Comments					
Control annual grass and weeds on the levee slopes and easements. Inspector Comments: Levee is well maintained.

Looking waterward slope in compliance with standards.

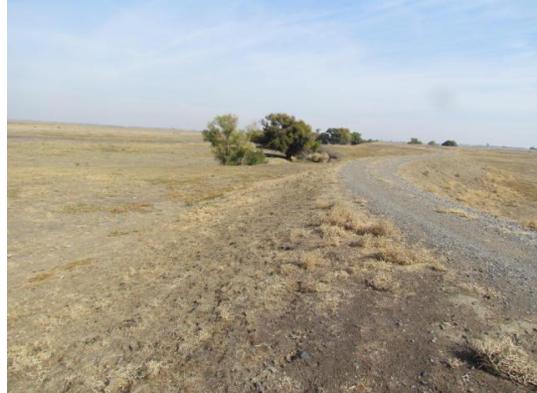
Photo 2 of 2 : FA_2014_NA0010_128_2_20141110_00002.jpg

Looking at landward slope in compliance with standards.

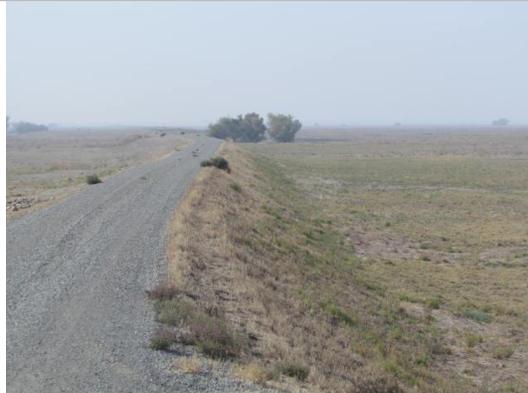
Photo 1 of 2 : FA_2014_NA0010_129_10_20141110_00002.jpg

LM Start	0.00	Rating **	A	Issue No.	10
LM End	3.31	Issue Type +	Ma	Location *	LS
Category	Earthen Levee		GPS Latitude/Longitude		
			Start	End	
Item	Vegetation			° 37.202309 °	
				° -120.695230 °	
DWR ID	DWR_NA0010_11_f_2014_10				
Action/Comments					
Control annual grass and weeds on the levee slopes and easements. Inspector Comments: No maintenance problems noted.

Looking at landward slope in compliance with standards.

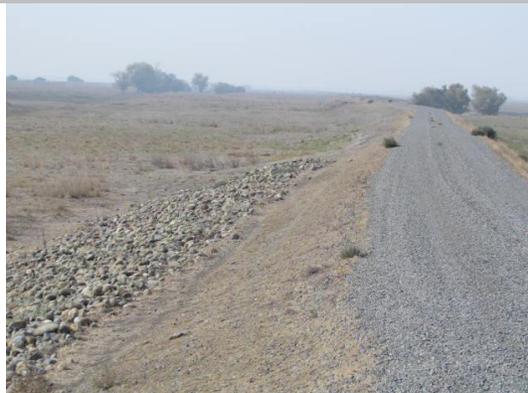
Photo 2 of 2 : FA_2014_NA0010_129_10_20141110_00004.jpg

Looking at waterward slope in compliance with standards.

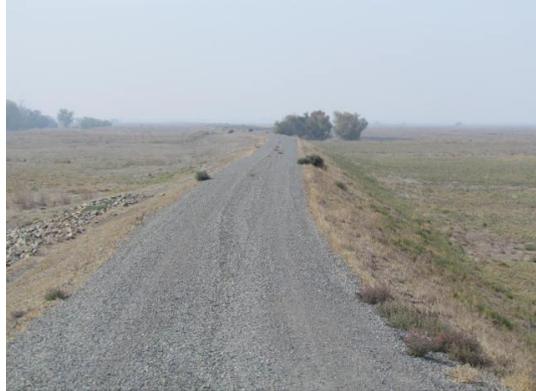
Photo 1 of 1 : FA_2014_NA0010_130_10_20141110_00001.jpg

LM Start	0.00	Rating **	A	Issue No.	10
LM End	3.33	Issue Type +	Ma	Location *	CR
Category	Earthen Levee		GPS Latitude/Longitude		
			Start	End	
Item	Vegetation			°	°
				°	°
DWR ID	DWR_NA0010_12_f_2014_10				
Action/Comments					
Control annual grass and weeds on the levee slopes and easements.

Looking at typical of levee in compliance with standards.

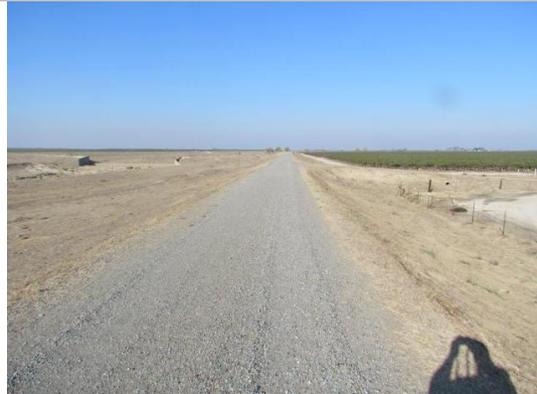
Photo 1 of 1 : FA_2014_NA0010_132_3_20141110_00001.jpg

LM Start	0.00	Rating **	A	Issue No.	3
LM End	1.26	Issue Type +	Ma	Location *	LS
Category	Earthen Levee		GPS Latitude/Longitude		
			Start	End	
Item	Vegetation		37.032401 °	37.032401 °	
			-120.441247 °	-120.441247 °	
DWR ID	DWR_NA0010_14_f_2014_3				
Action/Comments					
Control annual grass and weeds on the levee slopes and easements.

Looking at type view of levee in complies with standards.

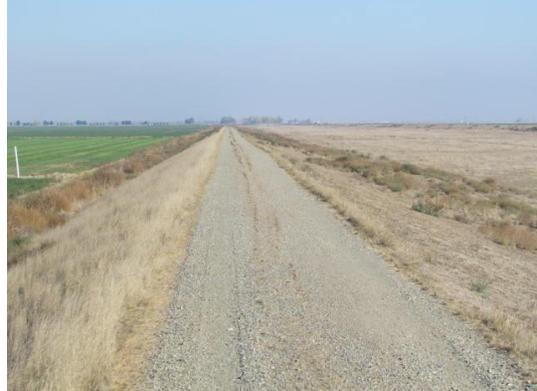
Photo 1 of 2 : FA_2014_NA0010_133_11_20141110_00002.jpg

LM Start	0.00	Rating **	A/W	Issue No.	11
LM End	1.99	Issue Type +	Ma	Location *	CR
Category	Earthen Levee		GPS Latitude/Longitude		
			Start	End	
Item	Crown Surface / Depressions / Rutting		36.996547 °	36.996587 °	
			-120.410220 °	-120.374503 °	
DWR ID	DWR_NA0010_15_s_2012_11				
Action/Comments					
Add appropriate material and re-grade the levee to bring the crown above the design elevation. Inspector Comments: Control vegetation on levee crown.

Looking east at typical view of levee in complies with standards

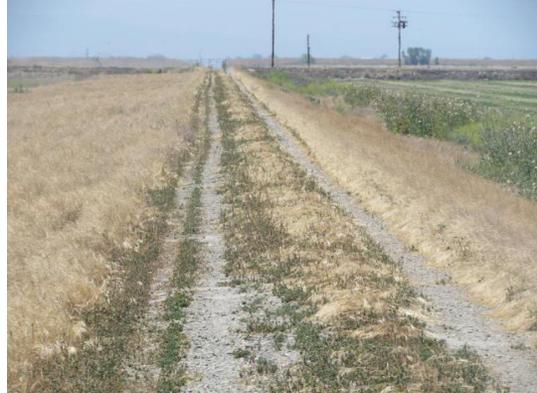
Photo 2 of 2 : FA_2014_NA0010_133_11_20141103_00001.jpg

Looking east at vegetation on levee crown.

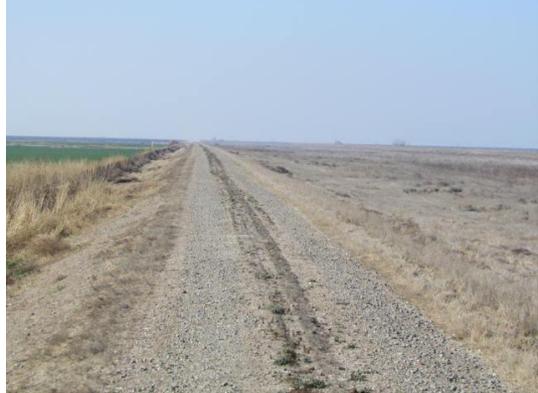
Photo 1 of 1 : FA_2014_NA0010_134_14_20141103_00001.jpg

LM Start	0.00	Rating **	A/W	Issue No.	14
LM End	1.98	Issue Type +	Ma	Location *	CR
Category	Earthen Levee		GPS Latitude/Longitude		
			Start	End	
Item	Crown Surface / Depressions / Rutting		36.995388 °	36.995507 °	
			-120.408738 °	-120.373592 °	
DWR ID	DWR_NA0010_16_s_2012_14				
Action/Comments					
Add appropriate material and re-grade the levee to bring the crown above the design elevation. Inspector Comments: Control vegetation on levee crown.

Looking west at the properly maintained levee crown.

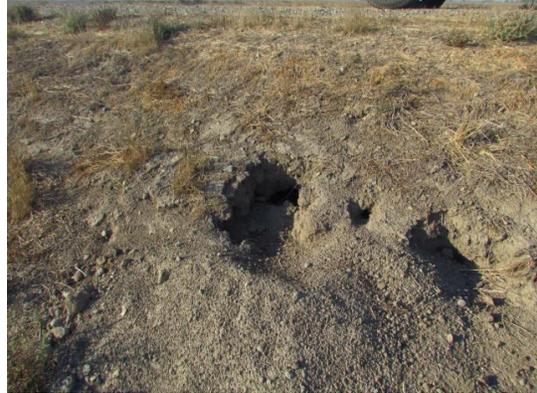
Photo 1 of 2 : FA_2014_NA0010_134_2_20141110_00002.jpg

LM Start	1.78	Rating **	M	Issue No.	2
LM End	1.78	Issue Type +	Ma	Location *	LS
Category	Earthen Levee		GPS Latitude/Longitude		
			Start	End	
Item	Animal Control		36.995487 °	36.995487 °	
			-120.377054 °	-120.377054 °	
DWR ID	DWR_NA0010_16_f_2014_2				
Action/Comments					
No rodents visible, but rodent burrows visible; need to backfill and compact or grout burrows. Inspector Comments: Large rodent holes on landward slope.

Looking at large rodent holes on landward slope.

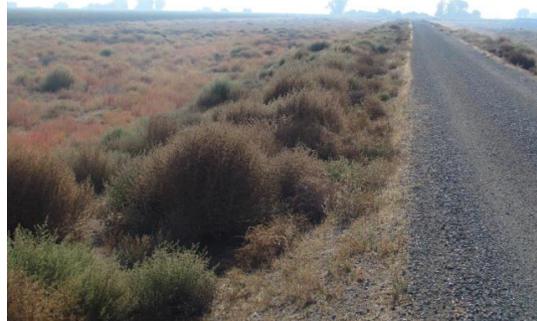
Photo 1 of 1 : FA_2014_NA0010_135_11_20141110_00004.jpg

LM Start	0.00	Rating **	M	Issue No.	11
LM End	16.09	Issue Type +	Ma	Location *	LS
Category	Earthen Levee		GPS Latitude/Longitude		
			Start	End	
Item	Vegetation			°	°
DWR ID	DWR_NA0010_17_f_2014_11				
Action/Comments					
Control annual grass and weeds on the levee slopes and easements. Inspector Comments: Tumble weeds on landward slope.

Looking south at typical view of tumble weeds on landward slope.

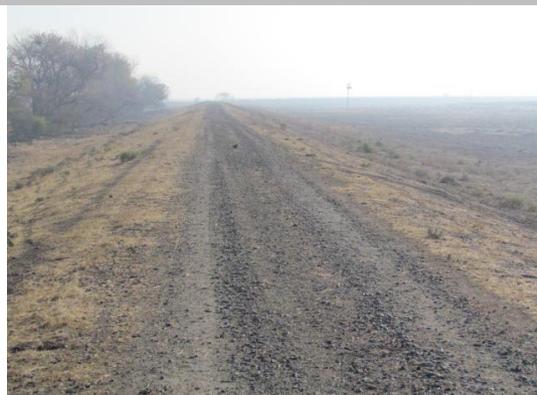
Photo 1 of 1 : FA_2014_NA0010_135_7_20141110_00005.jpg

LM Start	0.00	Rating **	A	Issue No.	7
LM End	5.77	Issue Type +	Ma	Location *	CR
Category	Earthen Levee		GPS Latitude/Longitude		
			Start	End	
Item	Vegetation		36.976430	°	36.908282
			-120.374748	°	-120.330995
DWR ID	DWR_NA0010_17_s_2012_7				
Action/Comments					
Control annual grass and weeds on the levee slopes and easements.

Looking south at typical view of levee crown in complies with standards.

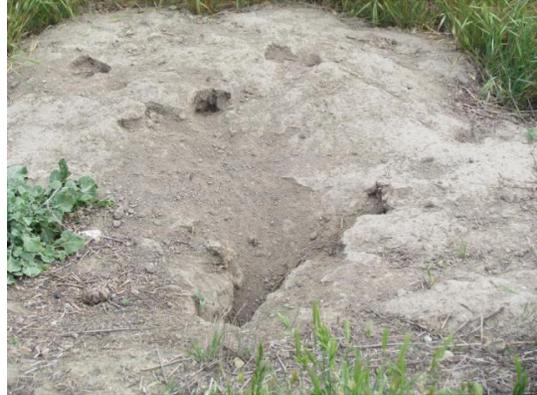
Photo 1 of 1 : FA_2014_NA0010_135_8_20141103_00002.jpg

LM Start	5.75	Rating **	M	Issue No.	8
LM End	5.90	Issue Type +	Ma	Location *	LS
Category	Earthen Levee		GPS Latitude/Longitude		
			Start	End	
Item	Animal Control		36.908605 °	36.906507 °	
			-120.331112 °	-120.330353 °	
DWR ID	DWR_NA0010_17_s_2012_8				
Action/Comments					
Exterminate rodents and backfill and compact or grout burrows.

Looking at several rodent holes on landside slope.

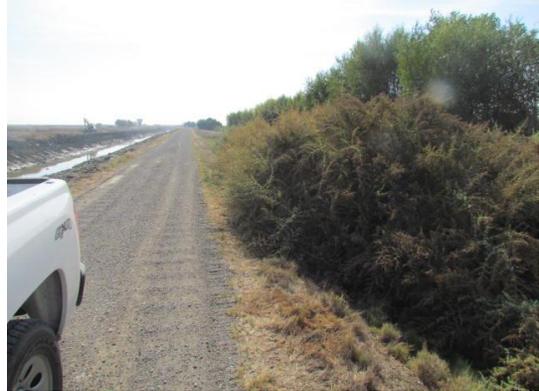
Photo 1 of 1 : FA_2014_NA0010_138_21_20141110_00014.jpg

LM Start	0.53	Rating **	M	Issue No.	21
LM End	0.53	Issue Type +	Ma	Location *	LS
Category	Earthen Levee		GPS Latitude/Longitude		
			Start	End	
Item	Vegetation		37.213006 °	37.213006 °	
			-120.698019 °	-120.698019 °	
DWR ID	DWR_NA0010_22A_f_2014_21				
Action/Comments					
Remove the wild growth other than native grasses from the levee slopes. Inspector Comments: Dense brush on landward slope.

Looking south at dense brushes on landward slope.

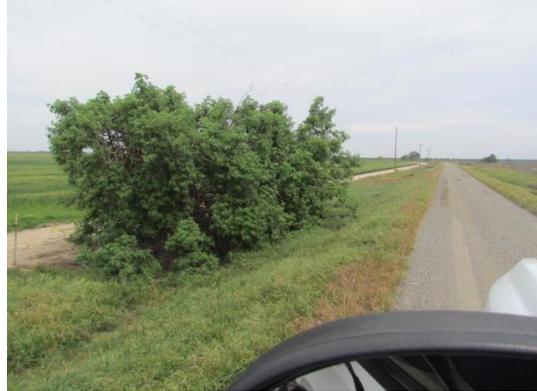
Photo 1 of 1 : FA_2014_NA0010_139_15_20141103_00014.jpg

LM Start	2.85	Rating **	M	Issue No.	15
LM End	2.85	Issue Type +	Ma	Location *	LS
Category	Earthen Levee		GPS Latitude/Longitude		
			Start	End	
Item	Vegetation		36.771537 °	36.771537 °	
			-120.240917 °	-120.240917 °	
DWR ID	DWR_NA0010_23_s_2012_15				
Action/Comments					
Elderberries are blocking visibility and flood fight capability.

Looking south at elderberry on landside toe and berm.

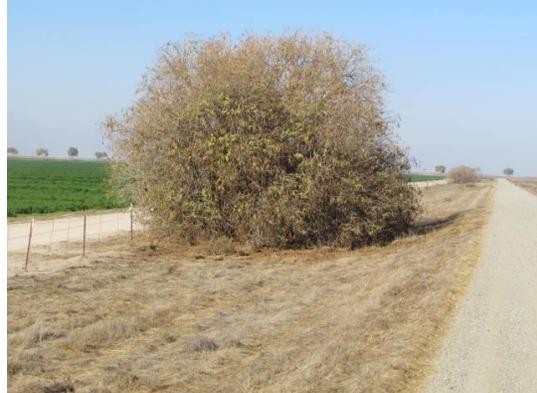
Photo 1 of 2 : FA_2014_NA0010_139_3_20141103_00003.jpg

LM Start	3.30	Rating **	M	Issue No.	3
LM End	3.30	Issue Type +	Ma	Location *	LS
Category	Earthen Levee		GPS Latitude/Longitude		
			Start	End	
Item	Vegetation		36.774403 °	36.774403 °	
			-120.234705 °	-120.234705 °	
DWR ID	DWR_NA0010_23_s_2012_3				
Action/Comments					
Elderberries are blocking visibility and flood fight capability.

Looking south at elderberry bush on landward toe. (Fall 2013)

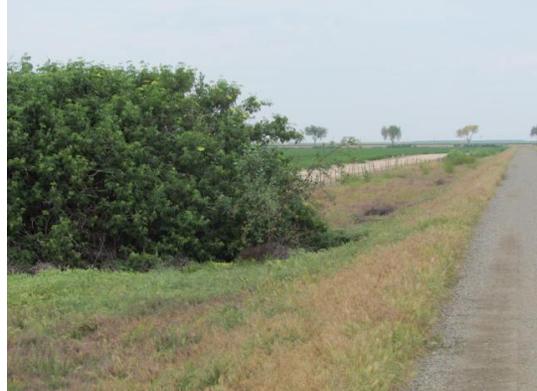
Photo 1 of 1 : FA_2014_NA0010_139_9_20141103_00008.jpg

LM Start	3.45	Rating **	M	Issue No.	9
LM End	3.45	Issue Type +	Ma	Location *	LS
Category	Earthen Levee		GPS Latitude/Longitude		
			Start	End	
Item	Vegetation		36.776537 °	36.776537 °	
			-120.234573 °	-120.234573 °	
DWR ID	DWR_NA0010_23_s_2012_9				
Action/Comments					
Elderberries are blocking visibility and flood fight capability.

Looking south at elderberry on landside toe and berm.

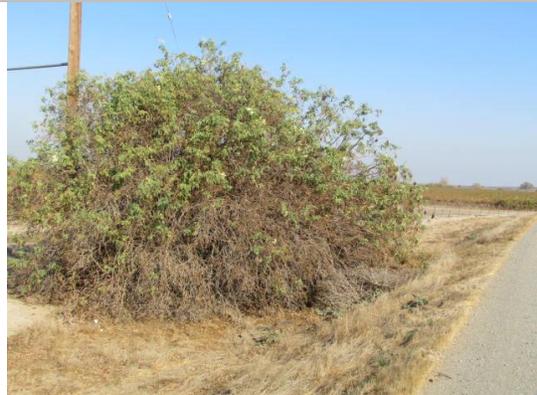
Photo 1 of 2 : FA_2014_NA0010_139_10_20141103_00009.jpg

LM Start	4.14	Rating **	M	Issue No.	10
LM End	4.14	Issue Type +	Ma	Location *	LS
Category	Earthen Levee		GPS Latitude/Longitude		
			Start	End	
Item	Vegetation		36.784212 °	36.784212 °	
			-120.228815 °	-120.228815 °	
DWR ID	DWR_NA0010_23_s_2012_10				
Action/Comments					
Elderberries are blocking visibility and flood fight capability.

Looking south at elderberry bush on landward toe. (Fall 2013)

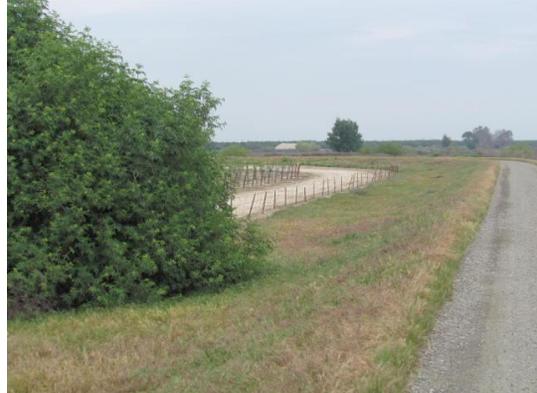
Photo 1 of 1 : FA_2014_NA0010_139_11_20141103_00011.jpg

LM Start	4.46	Rating **	M	Issue No.	11
LM End	4.46	Issue Type +	Ma	Location *	LS
Category	Earthen Levee		GPS Latitude/Longitude		
			Start	End	
Item	Vegetation		36.784523 °	36.784523 °	
			-120.223292 °	-120.223292 °	
DWR ID	DWR_NA0010_23_s_2012_11				
Action/Comments					
Elderberries are blocking visibility and flood fight capability.

Looking south at elderberry on landside toe and berm.

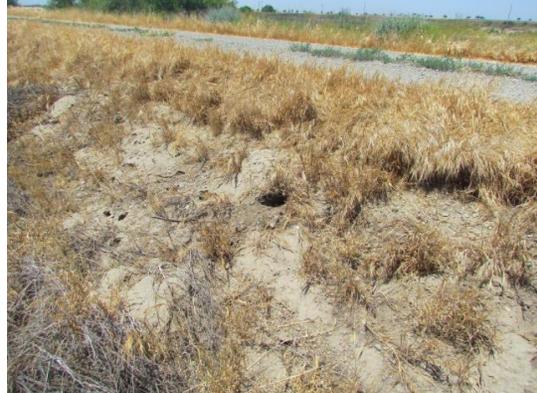
Photo 1 of 1 : FA_2014_NA0010_140_7_20141103_00002.jpg

LM Start	3.46	Rating **	M	Issue No.	7
LM End	3.46	Issue Type +	Ma	Location *	LS
Category	Earthen Levee		GPS Latitude/Longitude		
			Start	End	
Item	Animal Control		36.769345 °	36.769345 °	
			-120.238370 °	-120.238370 °	
DWR ID	DWR_NA0010_24_s_2012_7				
Action/Comments					
No rodents visible, but rodent burrows visible; need to backfill and compact or grout burrows. Inspector Comments: One of several rodent holes on landward slope.

Looking east at one of several rodent holes on landward slope.

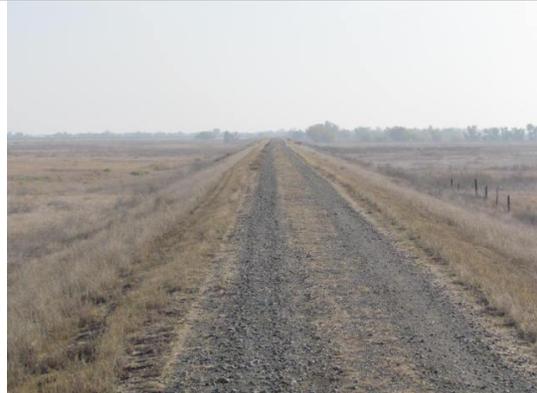
Photo 1 of 2 : FA_2014_NA0010_141_8_20141110_00002.jpg

LM Start	0.00	Rating **	A/W	Issue No.	8
LM End	2.47	Issue Type +	Ma	Location *	CR
Category	Earthen Levee		GPS Latitude/Longitude		
			Start	End	
Item	Crown Surface / Depressions / Rutting		37.296117° -120.880724°	37.271193° -120.866633°	
DWR ID	DWR_NA0010_25_s_2012_8				
Action/Comments					
Add appropriate material and re-grade the levee to bring the crown above the design elevation. Inspector Comments: Control weeds on levee crown.

Looking north at typical view of levee crown in complies with standards.
