**Flood Control Project Maintenance
Levee Inspections**

Maintenance Issue Types Only, Levee Inspection Report By Mile - Spring 2015

Lower San Joaquin Levee District

Waterway	Bank	Unit Miles	Inspection Start/End	Inspector
Unit No. 01 San Joaquin River	Right	22.52	05/18/2015 05/22/2015	Richard Willoughby

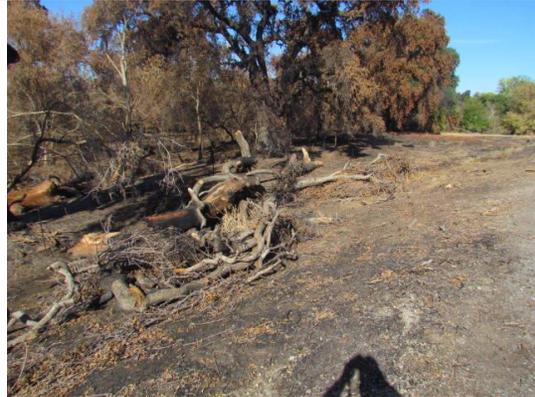
Photo 2 of 2 : SP_2015_NA0010_118_98_20150309_00013.jpg

LM Start	0.06	Rating **	A/W	Issue No.	98 (cont)
LM End	0.06	Issue Type +	Ma	Location *	WS
Category	Earthen Levee			GPS Latitude/Longitude	
				Start	End
Item	Encroachments			37.348157 °	37.348157 °
				-120.959658 °	-120.959658 °
DWR ID	DWR_NA0010_01_f_2014_98				
Action/Comments					
Tree or limb Inspector Comments: Downed tree limbs due to fire along levee slope.

Looking north at tree limbs on waterward toe.

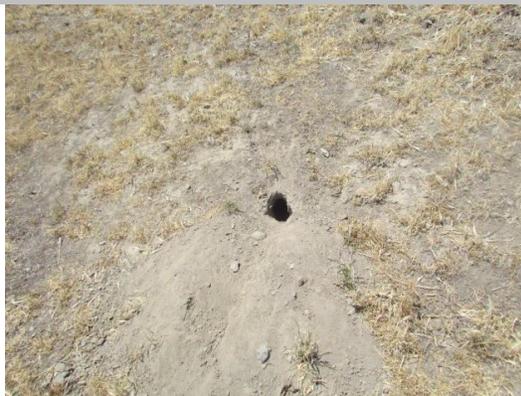
Photo 1 of 1 : SP_2015_NA0010_118_1_20150309_00001.jpg

LM Start	0.23	Rating **	M	Issue No.	1
LM End	0.39	Issue Type +	Ma	Location *	LS
Category	Earthen Levee		GPS Latitude/Longitude		
			Start	End	
Item	Animal Control		37.346152 °	37.343935 °	
			-120.961402 °	-120.962536 °	
DWR ID	DWR_NA0010_01_s_2012_1				
Action/Comments					
Exterminate rodents and backfill and compact or grout burrows. Inspector Comments: Typical view of several rodent holes on landward slope.

Looking at typical rodent holes on landward slope.

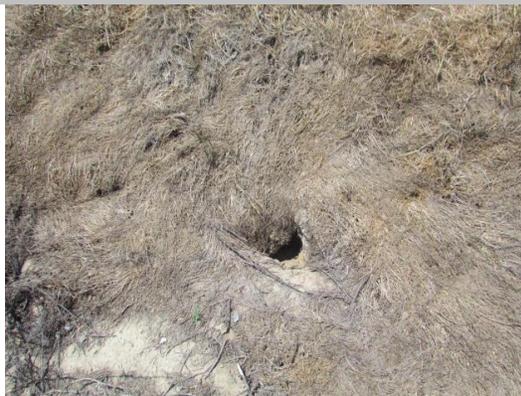
Photo 1 of 1 : SP_2015_NA0010_118_10_20150527_00180.jpg

LM Start	3.16	Rating **	U	Issue No.	10
LM End	3.16	Issue Type +	Ma	Location *	LS
Category	Earthen Levee		GPS Latitude/Longitude		
			Start	End	
Item	Animal Control		37.321053 °	37.321053 °	
			-120.928785 °	-120.928785 °	
DWR ID	DWR_NA0010_01_s_2012_10				
Action/Comments					
No rodents visible, but rodent burrows visible; need to backfill and compact or grout burrows. Inspector Comments: Several rodent holes noted in this section.

Looking at typical view of rodent holes on landward slope.

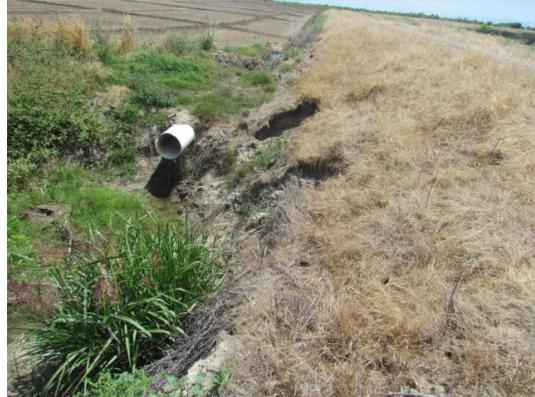
Photo 1 of 3 : SP_2015_NA0010_118_1179_20150527_00181.jpg

LM Start	3.47	Rating **	U	Issue No.	1179
LM End	3.47	Issue Type +	Ma	Location *	LS
Category	Earthen Levee			GPS Latitude/Longitude	
				Start	End
Item	Erosion / Bank Caving			37.317057 °	37.317057 °
				-120.926443 °	-120.926443 °
DWR ID	DWR_NA0010_01_s_2015_1179				
Action/Comments					
Note and monitor erosion site. Inspector Comments: Several erosions greater than three inches on landward slope.

Looking south at erosion on landward slope and toe.

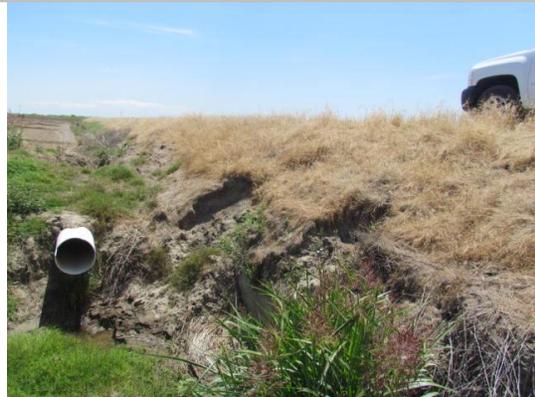
Photo 2 of 3 : SP_2015_NA0010_118_1179_20150527_00182.jpg

Looking southwest at erosion on landward slope and toe.

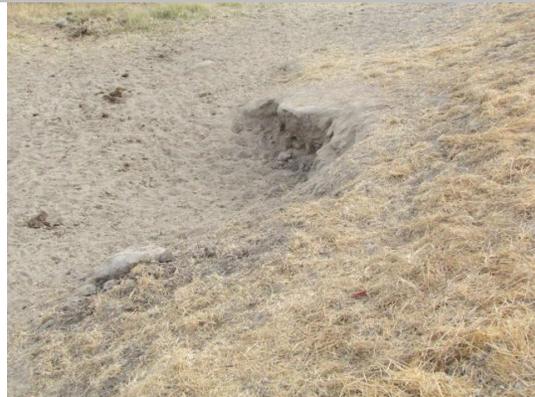
Photo 2 of 3 : SP_2015_NA0010_118_9_20150309_00005.jpg

LM Start	4.69	Rating **	A/W	Issue No.	9
LM End	4.69	Issue Type +	Ma	Location *	LS
Category	Earthen Levee			GPS Latitude/Longitude	
				Start	End
Item	Animal Control			37.302398 °	37.302398 °
				-120.920920 °	-120.920920 °
DWR ID	DWR_NA0010_01_s_2013_9				
Action/Comments					
Repair the levee slope damaged by livestock and prevent large animal access. Inspector Comments: Levee landward toe damaged by livestock.

Looking southeast at erosion on landward toe.

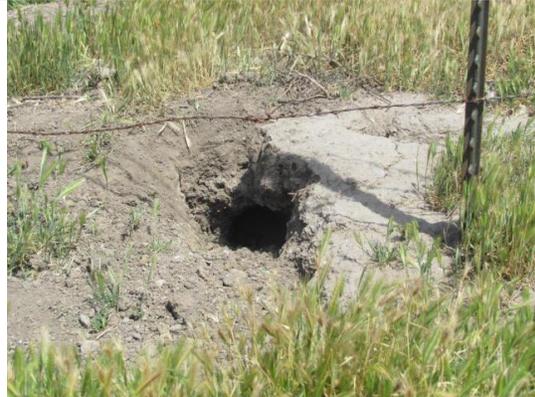
Photo 1 of 3 : SP_2015_NA0010_118_116_20150309_00016.jpg

LM Start	5.72	Rating **	A/W	Issue No.	116
LM End	5.72	Issue Type +	Ma	Location *	LS
Category	Earthen Levee			GPS Latitude/Longitude	
				Start	End
Item	Animal Control			37.304057 °	37.304057 °
				-120.907200 °	-120.907200 °
DWR ID	DWR_NA0010_01_s_2012_116				
Action/Comments					
No rodents visible, but rodent burrows visible; need to backfill and compact or grout burrows. Inspector Comments: Large rodent holes on landside slope near fence pole.

Looking east at one of several rodent holes on landside shoulder and slope.

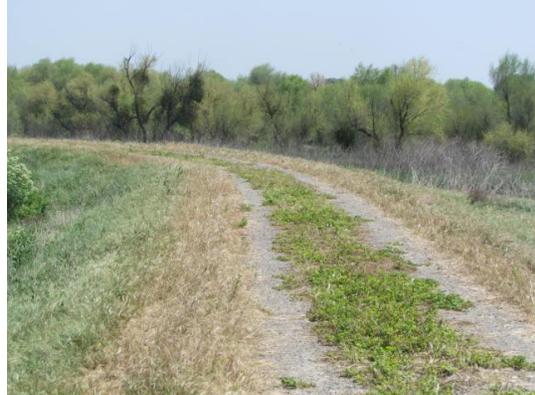
Photo 1 of 3 : SP_2015_NA0010_118_117_20150309_00019.jpg

LM Start	9.16	Rating **	M	Issue No.	117
LM End	9.78	Issue Type +	Ma	Location *	CR
Category	Earthen Levee			GPS Latitude/Longitude	
				Start	End
Item	Crown Surface / Depressions / Rutting			37.296145 °	37.293077 °
				-120.848588 °	-120.839170 °
DWR ID	DWR_NA0010_01_s_2012_117				
Action/Comments					
Add appropriate material and re-grade the levee to bring the crown above the design elevation. Inspector Comments: Control vegetation on levee crown.

Looking south at typical view of vegetation on levee crown.

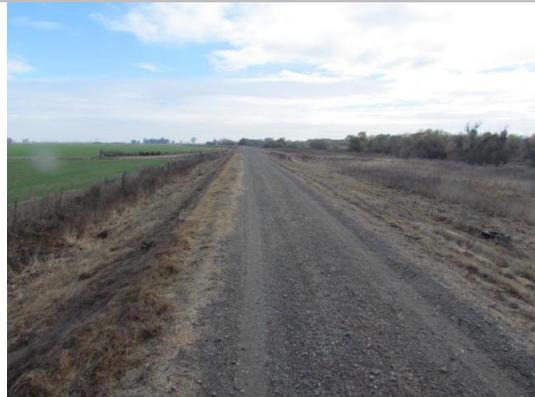
Photo 2 of 3 : SP_2015_NA0010_118_117_20150309_00020.jpg

Looking south at levee crown. (Fall 2013)

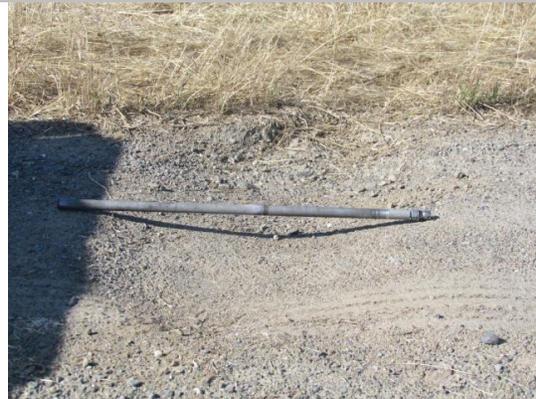
Photo 2 of 2 : SP_2015_NA0010_118_14_20150527_00187.jpg

LM Start	9.57	Rating **	M	Issue No.	14
LM End	9.57	Issue Type +	Ma	Location *	CR
Category	Earthen Levee			GPS Latitude/Longitude	
				Start	End
Item	Crown Surface / Depressions / Rutting			37.295517 °	37.295517 °
				-120.841452 °	-120.841452 °
DWR ID	DWR_NA0010_01_s_2015_14				
Action/Comments					
Repair depressions or ruts in the crown or slope. Inspector Comments: Depression greater than 3" deep by 18" wide by 18" long on levee crown

Looking west at depression on levee crown.

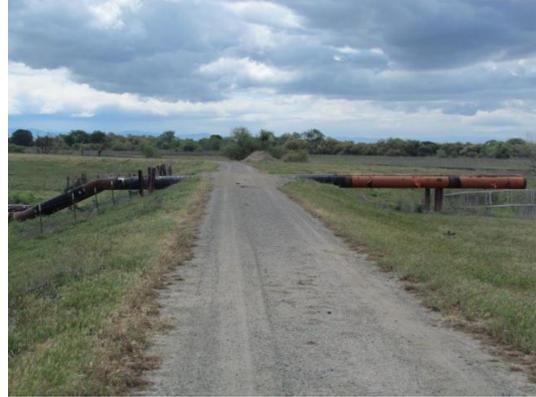
Photo 1 of 1 : SP_2015_NA0010_118_8_20150309_00004.jpg

LM Start	19.32	Rating **	M	Issue No.	8
LM End	19.32	Issue Type +	Ma	Location *	CR
Category	Earthen Levee		GPS Latitude/Longitude		
			Start	End	
Item	Encroachments		37.200923 °	37.200923 °	
			-120.756987 °	-120.756987 °	
DWR ID	DWR_NA0010_01_s_2012_8				
Action/Comments					
Pipe Inspector Comments: Farmer installed a pipe across levee crown, landside and waterside slopes. Ramp is not according to standards.

Looking south at pipe across levee crown.

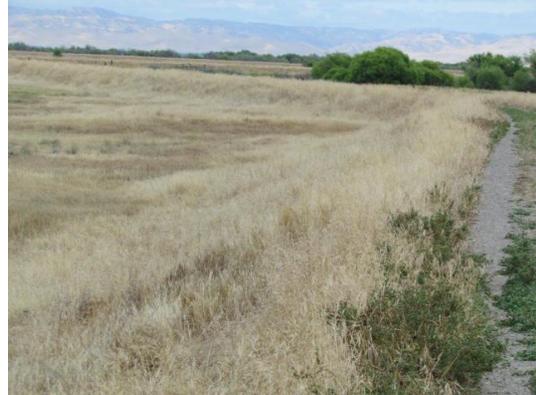
Photo 1 of 1 : SP_2015_NA0010_119_250_20150527_00006.jpg

LM Start	0.00	Rating **	M	Issue No.	250
LM End	7.84	Issue Type +	Ma	Location *	LS
Category	Earthen Levee			GPS Latitude/Longitude	
				Start	End
Item	Vegetation			37.296314 °	37.231606 °
				-120.880559 °	-120.812192 °
DWR ID	DWR_NA0010_02A_s_2015_250				
Action/Comments					
Control annual grass and weeds on the levee slopes and easements.

Looking west at typical view of landward slope.

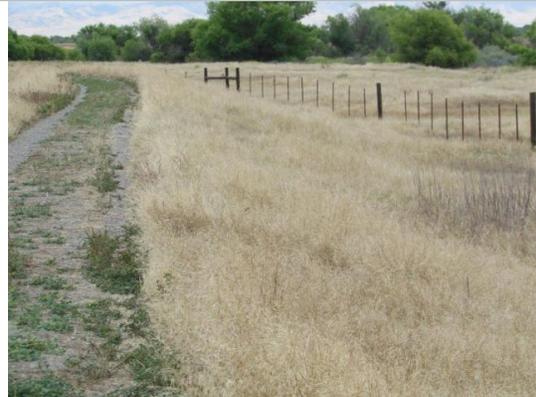
Photo 1 of 1 : SP_2015_NA0010_119_251_20150527_00007.jpg

LM Start	0.00	Rating **	M	Issue No.	251
LM End	7.84	Issue Type +	Ma	Location *	WS
Category	Earthen Levee			GPS Latitude/Longitude	
				Start	End
Item	Vegetation			37.296314 °	37.231601 °
				-120.880559 °	-120.812191 °
DWR ID	DWR_NA0010_02A_s_2015_251				
Action/Comments					
Control annual grass and weeds on the levee slopes and easements.

Looking northwest at typical view of waterward slope.

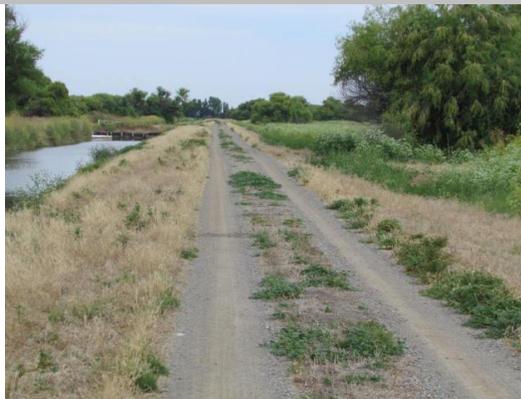
Photo 1 of 1 : SP_2015_NA0010_120_168_20150527_00006.jpg

LM Start	7.87	Rating **	M	Issue No.	168
LM End	13.22	Issue Type +	Ma	Location *	CR
Category	Earthen Levee		GPS Latitude/Longitude		
			Start	End	
Item	Vegetation		37.231604 °	37.178622 °	
			-120.812190 °	-120.764448 °	
DWR ID	DWR_NA0010_02B_s_2015_168				
Action/Comments					
Control annual grass and weeds on the levee slopes and easements. Inspector Comments: Control vegetation on levee crown.

Looking north at typical view of levee crown.

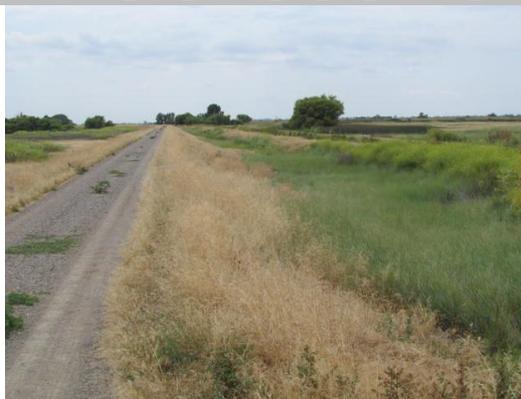
Photo 1 of 1 : SP_2015_NA0010_120_169_20150527_00008.jpg

LM Start	7.87	Rating **	M	Issue No.	169
LM End	13.79	Issue Type +	Ma	Location *	LS
Category	Earthen Levee		GPS Latitude/Longitude		
			Start	End	
Item	Vegetation		37.231604 °	°	
			-120.812190 °	°	
DWR ID	DWR_NA0010_02B_s_2015_169				
Action/Comments					
Control annual grass and weeds on the levee slopes and easements.

Looking northwest at typical view of waterward slope.

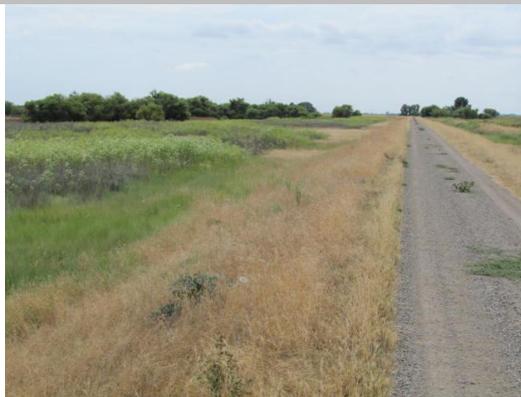
Photo 1 of 1 : SP_2015_NA0010_120_170_20150527_00007.jpg

LM Start	7.87	Rating **	M	Issue No.	170
LM End	13.79	Issue Type +	Ma	Location *	WS
Category	Earthen Levee		GPS Latitude/Longitude		
			Start	End	
Item	Vegetation		37.231603 °	°	
			-120.812190 °	°	
DWR ID	DWR_NA0010_02B_s_2015_170				
Action/Comments					
Control annual grass and weeds on the levee slopes and easements.

Looking northwest at typical view of waterward slope.

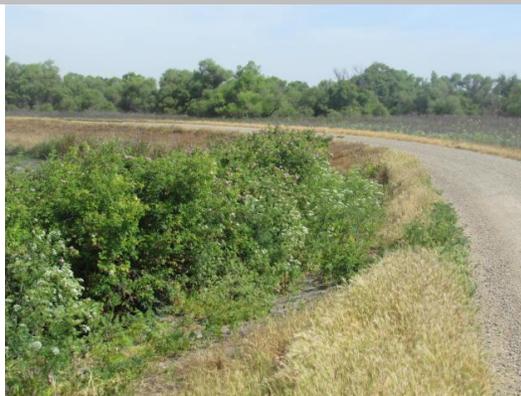
Photo 1 of 1 : SP_2015_NA0010_120_5_20150309_00005.jpg

LM Start	12.10	Rating **	A/W	Issue No.	5
LM End	12.10	Issue Type +	Ma	Location *	LS
Category	Earthen Levee		GPS Latitude/Longitude		
			Start	End	
Item	Vegetation		37.193504 °	37.193504 °	
			-120.763859 °	-120.763859 °	
DWR ID	DWR_NA0010_02B_s_2012_5				
Action/Comments					
Remove the wild growth other than native grasses from the levee slopes. Inspector Comments: Remove wild roses on landside toe.

Looking north at wildroses on landward slope.

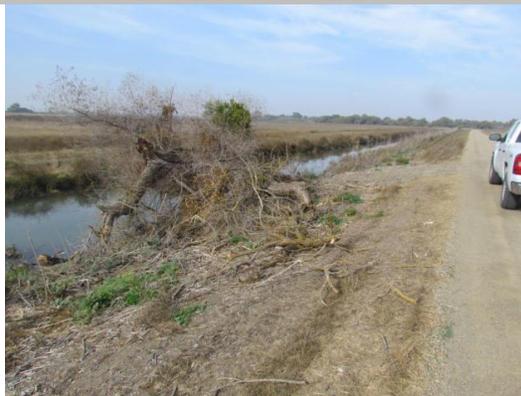
Photo 1 of 2 : SP_2015_NA0010_120_1_20150309_00001.jpg

LM Start	12.25	Rating **	M	Issue No.	1
LM End	12.25	Issue Type +	Ma	Location *	LS
Category	Earthen Levee		GPS Latitude/Longitude		
			Start	End	
Item	Encroachments		37.191500 °	37.191500 °	
			-120.764521 °	-120.764521 °	
DWR ID	DWR_NA0010_02B_f_2014_1				
Action/Comments					
Tree or limb Inspector Comments: Fallen tree limbs on landward slope.

Looking southwest at tree limb on waterward slope.

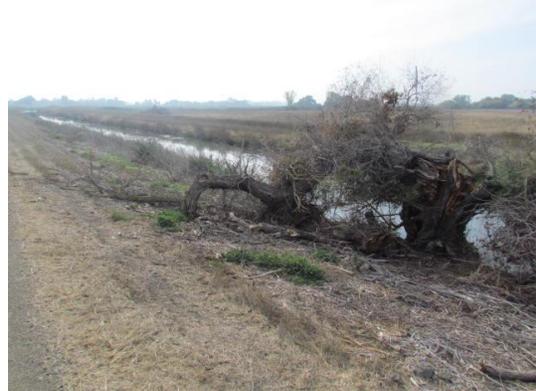
Photo 2 of 2 : SP_2015_NA0010_120_1_20150309_00002.jpg

LM Start	12.25	Rating **	M	Issue No.	1 (cont)
LM End	12.25	Issue Type +	Ma	Location *	LS
Category	Earthen Levee			GPS Latitude/Longitude	
				Start	End
Item	Encroachments			37.191500 °	37.191500 °
				-120.764521 °	-120.764521 °
DWR ID	DWR_NA0010_02B_f_2014_1				
Action/Comments					
Tree or limb Inspector Comments: Fallen tree limbs on landward slope.

Looking southwest at tree limb on waterward slope.

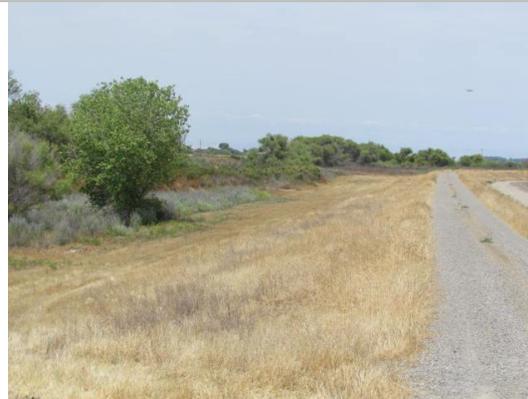
Photo 1 of 1 : SP_2015_NA0010_121_66_20150527_00023.jpg

LM Start	0.00	Rating **	M	Issue No.	66
LM End	2.10	Issue Type +	Ma	Location *	WS
Category	Earthen Levee		GPS Latitude/Longitude		
			Start	End	
Item	Vegetation		37.111728 °	37.088908 °	
			-120.587563 °	-120.566846 °	
DWR ID	DWR_NA0010_03_s_2015_66				
Action/Comments					
Control annual grass and weeds on the levee slopes and easements. Inspector Comments: Control annual growth on waterward slope.

Looking at typical view of waterward slope.

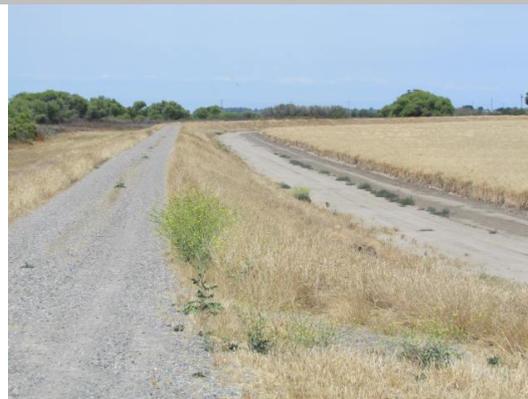
Photo 1 of 1 : SP_2015_NA0010_121_4_20150527_00024.jpg

LM Start	0.40	Rating **	M	Issue No.	4
LM End	2.09	Issue Type +	Ma	Location *	LS
Category	Earthen Levee		GPS Latitude/Longitude		
			Start	End	
Item	Vegetation		37.106450 °	37.088965 °	
			-120.586024 °	-120.566867 °	
DWR ID	DWR_NA0010_03_f_2014_4				
Action/Comments					
Control annual grass and weeds on the levee slopes and easements. Inspector Comments: Control growth on landward slope.

Looking at typical view of landward slope.

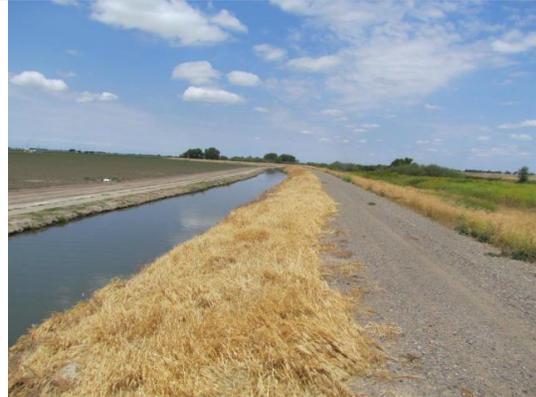
Photo 1 of 1 : SP_2015_NA0010_122_105_20150527_00051.jpg

LM Start	0.00	Rating **	M	Issue No.	105
LM End	1.19	Issue Type +	Ma	Location *	LS
Category	Earthen Levee		GPS Latitude/Longitude		
			Start	End	
Item	Vegetation		37.112570 °	37.100055 °	
			-120.589082 °	-120.580240 °	
DWR ID	DWR_NA0010_04_s_2015_105				
Action/Comments					
Control annual grass and weeds on the levee slopes and easements. Inspector Comments: Control growth on landward slope.

Looking at typical view of landward slope.

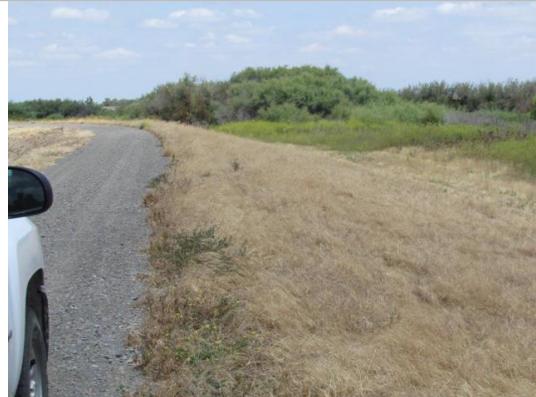
Photo 1 of 1 : SP_2015_NA0010_122_106_20150527_00052.jpg

LM Start	0.00	Rating **	M	Issue No.	106
LM End	1.41	Issue Type +	Ma	Location *	WS
Category	Earthen Levee		GPS Latitude/Longitude		
			Start	End	
Item	Vegetation		37.112570 °	37.097534 °	
			-120.589082 °	-120.578145 °	
DWR ID	DWR_NA0010_04_s_2015_106				
Action/Comments					
Control annual grass and weeds on the levee slopes and easements. Inspector Comments: Control growth on waterward slope.

Looking at typical view of waterward slope.

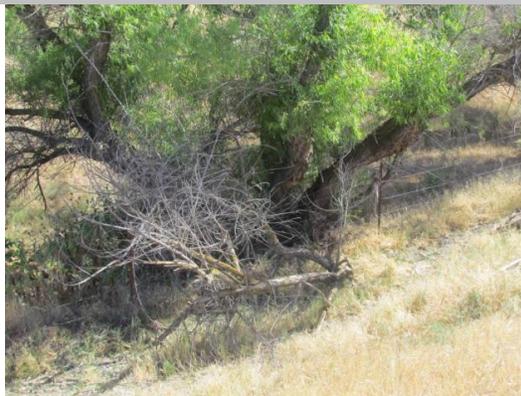
Photo 1 of 2 : SP_2015_NA0010_123_1308_20150527_00459.jpg

LM Start	2.82	Rating **	M	Issue No.	1308
LM End	2.82	Issue Type +	Ma	Location *	LS
Category	Earthen Levee			GPS Latitude/Longitude	
				Start	End
Item	Encroachments			37.256783 °	37.256783 °
				-120.785438 °	-120.785438 °
DWR ID	DWR_NA0010_05_s_2015_1308				
Action/Comments					
Tree or limb Inspector Comments: Discard dead tree limbs at landward toe.

Looking southeast at dead tree limbs on landward toe.

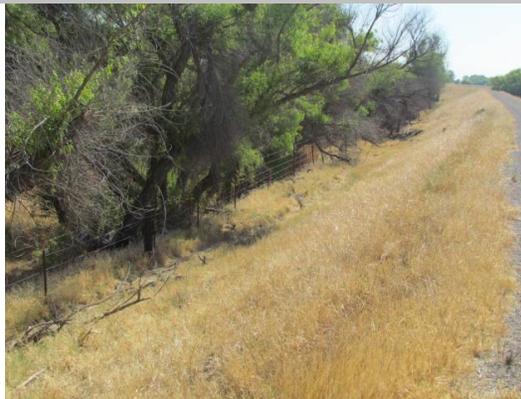
Photo 2 of 2 : SP_2015_NA0010_123_1308_20150527_00460.jpg

Looking south at several dead tree limbs on landward toe.

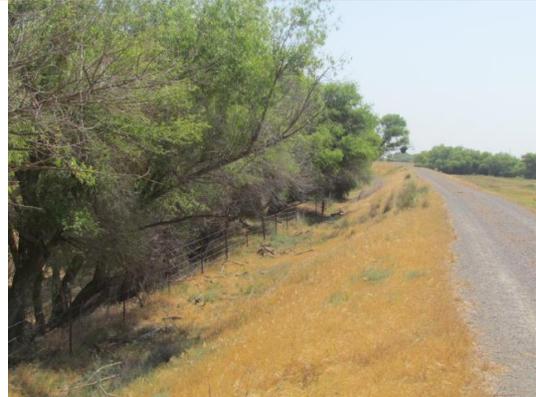
Photo 1 of 2 : SP_2015_NA0010_123_3_20150309_00002.jpg

LM Start	2.82	Rating **	A/W	Issue No.	3
LM End	2.87	Issue Type +	Ma	Location *	LS
Category	Earthen Levee		GPS Latitude/Longitude		
			Start	End	
Item	Trim / Thin Trees		37.256803 °	37.256835 °	
			-120.785407 °	-120.784528 °	
DWR ID	DWR_NA0010_05_s_2012_3				
Action/Comments					
Thin trees to allow visibility of the ground and room to flood fight.

Looking south at trimmed trees on landward slope and toe.

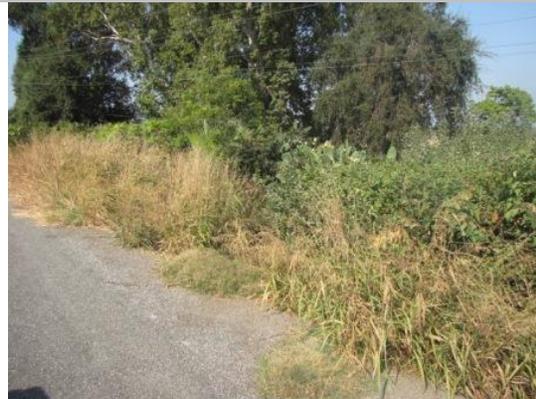
Photo 2 of 2 : SP_2015_NA0010_123_3_20150309_00003.jpg

Looking south at dense trees on landside slope.

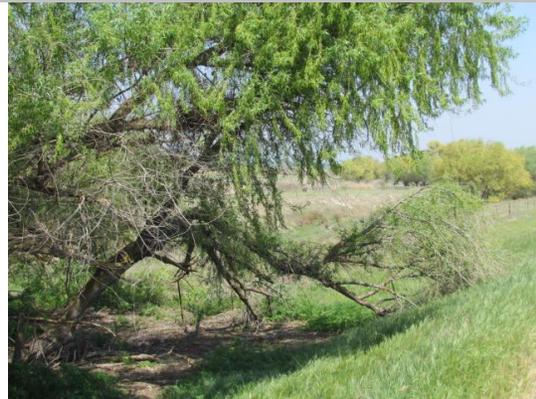
Photo 1 of 1 : SP_2015_NA0010_123_2_20150309_00001.jpg

LM Start	3.55	Rating **	A/W	Issue No.	2
LM End	3.55	Issue Type +	Ma	Location *	LS
Category	Earthen Levee			GPS Latitude/Longitude	
				Start	End
Item	Encroachments			37.255192 °	37.255192 °
				-120.773595 °	-120.773595 °
DWR ID	DWR_NA0010_05_s_2012_2				
Action/Comments					
Tree or limb Inspector Comments: Downed tree limb on landside slope and toe.

Looking south at down tree limb on landside slope and toe.

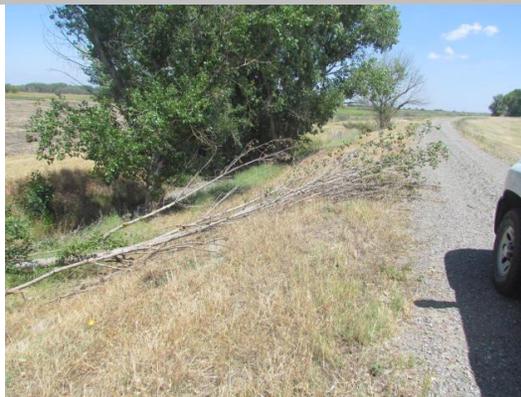
Photo 1 of 1 : SP_2015_NA0010_123_1310_20150527_00464.jpg

LM Start	13.01	Rating **	M	Issue No.	1310
LM End	13.01	Issue Type +	Ma	Location *	LS
Category	Earthen Levee		GPS Latitude/Longitude		
			Start	End	
Item	Encroachments		37.175587 °	37.175587 °	
			-120.638730 °	-120.638730 °	
DWR ID	DWR_NA0010_05_s_2015_1310				
Action/Comments					
Tree or limb Inspector Comments: Downed tree on landward slope.

Looking south at fallen tree limbs on waterward slope.

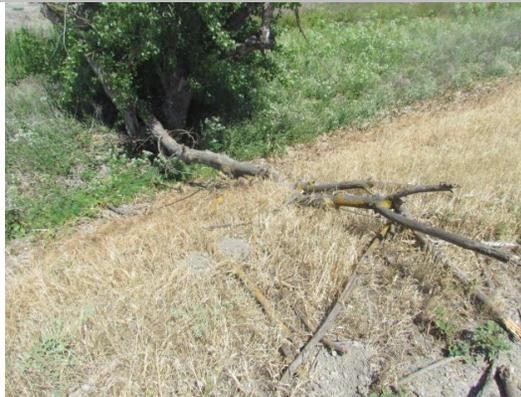
Photo 1 of 1 : SP_2015_NA0010_123_1311_20150527_00465.jpg

LM Start	13.59	Rating **	M	Issue No.	1311
LM End	13.59	Issue Type +	Ma	Location *	LS
Category	Earthen Levee		GPS Latitude/Longitude		
			Start	End	
Item	Encroachments		37.169607 °	37.169607 °	
			-120.631358 °	-120.631358 °	
DWR ID	DWR_NA0010_05_s_2015_1311				
Action/Comments					
Tree or limb Inspector Comments: Downed tree on landward slope.

Looking east at a fallen tree limbs on waterward slope.

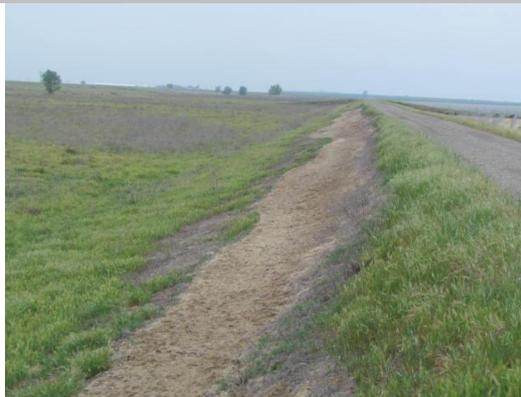
Photo 1 of 3 : SP_2015_NA0010_123_171_20150309_00011.jpg

LM Start	29.68	Rating **	M	Issue No.	171
LM End	29.80	Issue Type +	Ma	Location *	WS
Category	Earthen Levee		GPS Latitude/Longitude		
			Start	End	
Item	Erosion / Bank Caving		37.020272 °	37.018712 °	
			-120.433737 °	-120.432682 °	
DWR ID	DWR_NA0010_05_s_2014_171				
Action/Comments					
Note and monitor erosion site. Inspector Comments: Waterside erosion caused by livestock.

Looking south at erosion caused by livestock on landside slope.

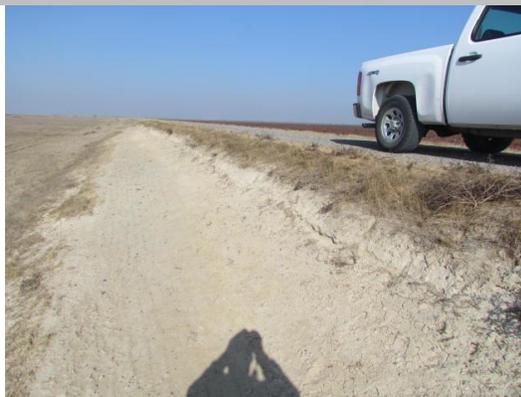
Photo 2 of 3 : SP_2015_NA0010_123_171_20150309_00012.jpg

Looking south at livestock erosion on landward slope.

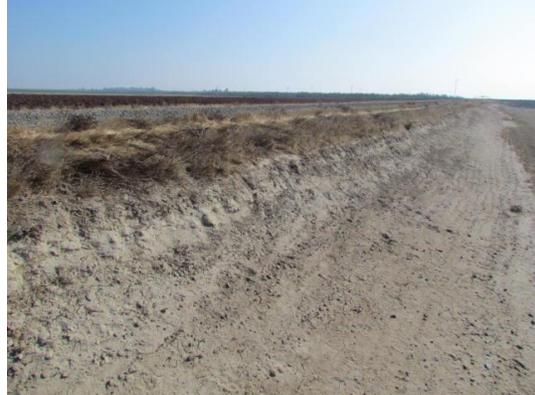
Photo 3 of 3 : SP_2015_NA0010_123_171_20150309_00013.jpg

LM Start	29.68	Rating **	M	Issue No.	171 (cont)
LM End	29.80	Issue Type +	Ma	Location *	WS
Category	Earthen Levee		GPS Latitude/Longitude		
			Start	End	
Item	Erosion / Bank Caving		37.020272 °	37.018712 °	
			-120.433737 °	-120.432682 °	
DWR ID	DWR_NA0010_05_s_2014_171				
Action/Comments					
Note and monitor erosion site. Inspector Comments: Waterside erosion caused by livestock.

Looking east at livestock eroision on landward slope.

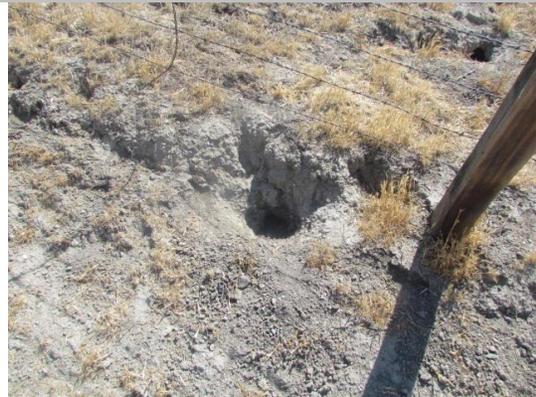
Photo 1 of 2 : SP_2015_NA0010_124_10_20150309_00011.jpg

LM Start	4.66	Rating **	M	Issue No.	10
LM End	4.66	Issue Type +	Ma	Location *	LS
Category	Earthen Levee			GPS Latitude/Longitude	
				Start	End
Item	Animal Control			37.243540 °	37.243540 °
				-120.760782 °	-120.760782 °
DWR ID	DWR_NA0010_06_s_2012_10				
Action/Comments					
No rodents visible, but rodent burrows visible; need to backfill and compact or grout burrows. Inspector Comments: Rodent holes next to fence post on landward slope.

Looking at rodent hole along fence line on landward slope.

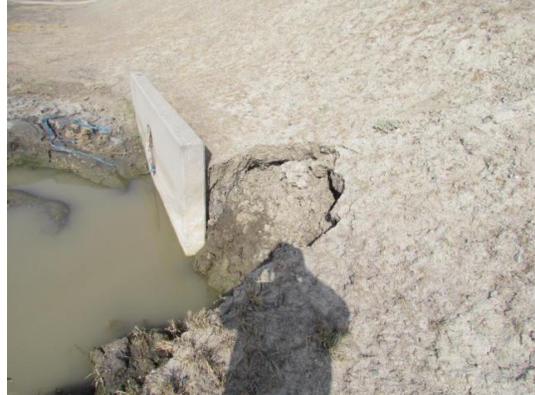
Photo 2 of 2 : SP_2015_NA0010_124_65_20150309_00017.jpg

LM Start	5.98	Rating **	U	Issue No.	65 (cont)
LM End	5.98	Issue Type +	Ma	Location *	LS
Category	Interior Drainage & Piping Systems			GPS Latitude/Longitude	
				Start	End
Item	Erosion Areas			37.236372 °	37.236372 °
				-120.739706 °	-120.739706 °
DWR ID	DWR_NA0010_06_f_2014_65				
Action/Comments					
Inspector Comments: Erosion on right side of headwall at landward toe.

Looking south erosion around headwall of drainage structure on landward toe.

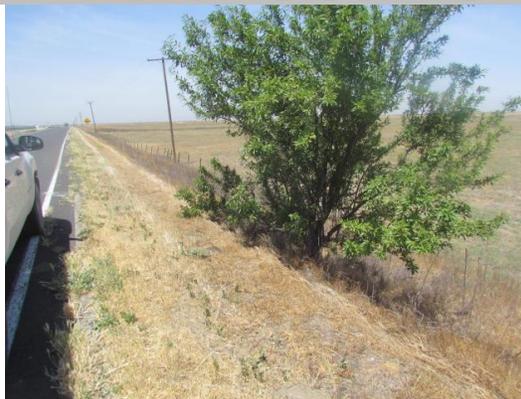
Photo 1 of 1 : SP_2015_NA0010_124_14_20150309_00013.jpg

LM Start	11.49	Rating **	M	Issue No.	14
LM End	11.49	Issue Type +	Ma	Location *	WS
Category	Earthen Levee		GPS Latitude/Longitude		
			Start	End	
Item	Trim / Thin Trees		37.186189 °	37.186189 °	
			-120.668476 °	-120.668476 °	
DWR ID	DWR_NA0010_06_s_2015_14				
Action/Comments					
Trim trees to at least five feet above ground level. Inspector Comments: Almond tree located along Sandy Mush Rd. on waterward slope.

Looking east at tree on waterward slope.

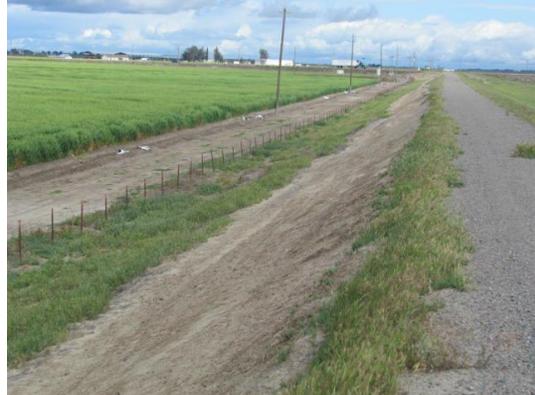
Photo 3 of 3 : SP_2015_NA0010_124_5_20150309_00008.jpg

LM Start	24.58	Rating **	M	Issue No.	5 (cont)
LM End	24.93	Issue Type +	Ma	Location *	LS
Category	Earthen Levee			GPS Latitude/Longitude	
				Start	End
Item	Slope Stability			37.071198 °	°
				-120.519220 °	°
DWR ID	DWR_NA0010_06_s_2012_5				
Action/Comments					
Repair the levee slope damaged by foot traffic and prevent access where possible. Inspector Comments: Landside erosion caused by livestock.

Looking north at livestock erosion on landside slope. (Fall 2014)

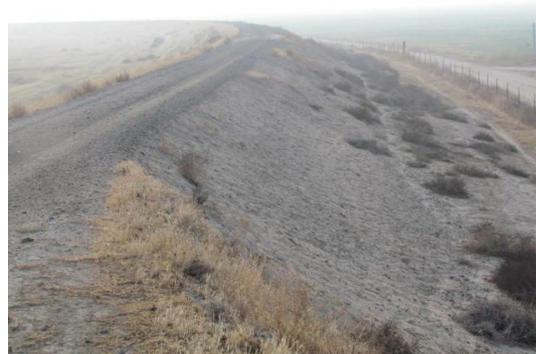
Photo 3 of 5 : SP_2015_NA0010_124_3_20150309_00004.jpg

LM Start	27.64	Rating **	M	Issue No.	3 (cont)
LM End	27.97	Issue Type +	Ma	Location *	LS

Looking south at livestock erosion on landward slope. (Fall 2013)

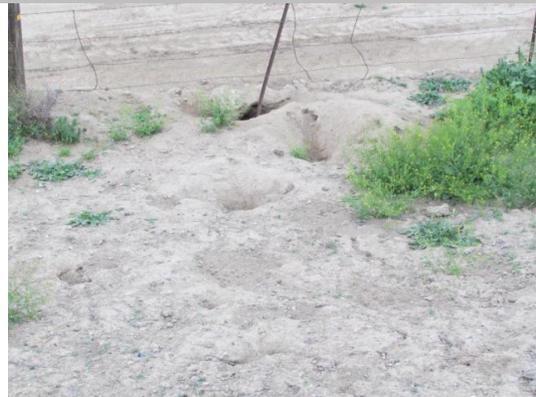
Photo 1 of 2 : SP_2015_NA0010_124_2_20150309_00001.jpg

LM Start	31.10	Rating **	M	Issue No.	2
LM End	31.10	Issue Type +	Ma	Location *	LS
Category	Earthen Levee			GPS Latitude/Longitude	
				Start	End
Item	Animal Control			37.017955 °	37.017955 °
				-120.435017 °	-120.435017 °
DWR ID	DWR_NA0010_06_s_2012_2				
Action/Comments					
Exterminate rodents and backfill and compact or grout burrows.

Looking west at rodent holes on landside slope and toe near fence line.

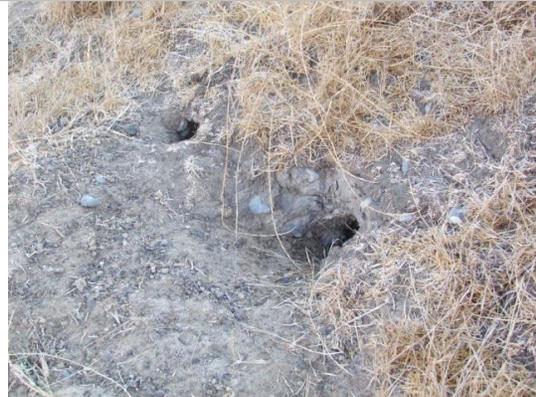
Photo 1 of 2 : SP_2015_NA0010_125_1_20150309_00001.jpg

LM Start	1.22	Rating **	M	Issue No.	1
LM End	1.22	Issue Type +	Ma	Location *	LS
Category	Earthen Levee		GPS Latitude/Longitude		
			Start	End	
Item	Animal Control		37.264387 °	37.264387 °	
			-120.755805 °	-120.755805 °	
DWR ID	DWR_NA0010_07_f_2012_1				
Action/Comments					
Exterminate rodents and backfill and compact or grout burrows.

Looking north at several rodent holes on landward slope.

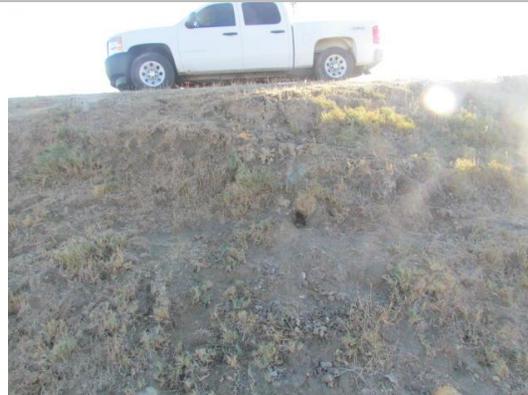
Photo 1 of 1 : SP_2015_NA0010_125_11_20150309_00008.jpg

LM Start	1.25	Rating **	A/W	Issue No.	11
LM End	1.25	Issue Type +	Ma	Location *	LS
Category	Earthen Levee			GPS Latitude/Longitude	
				Start	End
Item	Slope Stability			37.264367 °	37.264367 °
				-120.755218 °	-120.755218 °
DWR ID	DWR_NA0010_07_f_2014_11				
Action/Comments					
Repair the levee slope damaged by foot traffic and prevent access where possible. Inspector Comments: Slope damage caused by livestock and rodent activity.

Looking west at slope damage and rodent activity on landward slope.

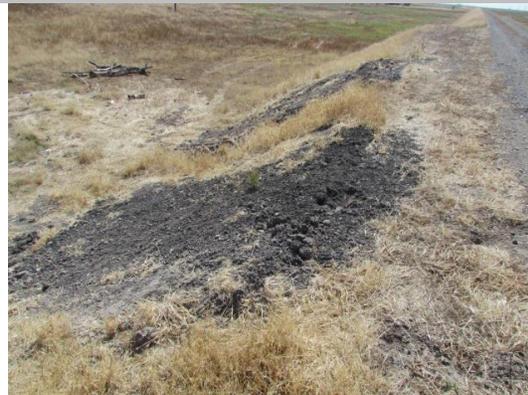
Photo 1 of 5 : SP_2015_NA0010_125_3_20150528_00012.jpg

LM Start	1.50	Rating **	A/W	Issue No.	3
LM End	1.50	Issue Type +	Ma	Location *	LS
Category	Earthen Levee			GPS Latitude/Longitude	
				Start	End
Item	Animal Control			37.263930 °	37.263930 °
				-120.750680 °	-120.750680 °
DWR ID	DWR_NA0010_07_s_2012_3				
Action/Comments					
Repair the levee slope damaged by livestock and prevent large animal access. Inspector Comments: Erosion on landward slope has been repaired by district. Landward toe erosion not repaired.

Looking east at repaired landward slope.

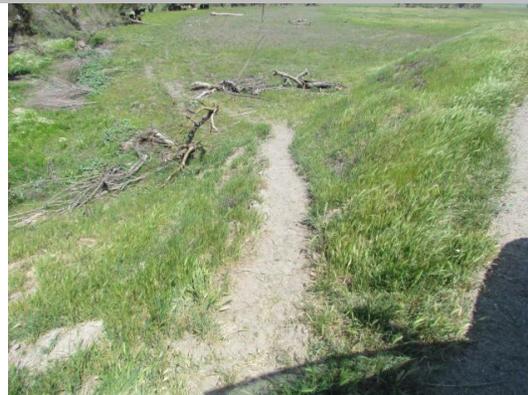
Photo 2 of 5 : SP_2015_NA0010_125_3_20150309_00003.jpg

Looking northeast at landside slope damaged by livestock.

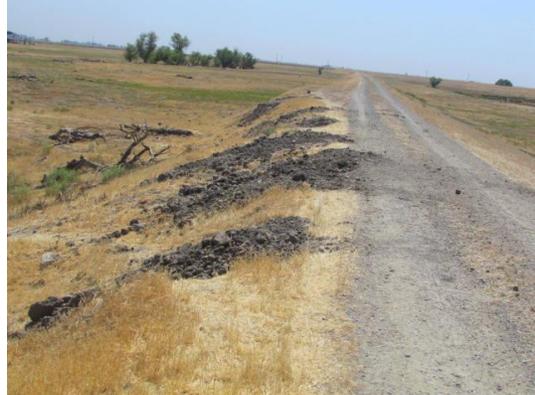
Photo 3 of 5 : SP_2015_NA0010_125_3_20150309_00004.jpg

LM Start	1.50	Rating **	A/W	Issue No.	3 (cont)
LM End	1.50	Issue Type +	Ma	Location *	LS
Category	Earthen Levee			GPS Latitude/Longitude	
				Start	End
Item	Animal Control			37.263930 °	37.263930 °
				-120.750680 °	-120.750680 °
DWR ID	DWR_NA0010_07_s_2012_3				
Action/Comments					
Repair the levee slope damaged by livestock and prevent large animal access. Inspector Comments: Erosion on landward slope has been repaired by district. Landward toe erosion not repaired.

Looking south at landward slope.

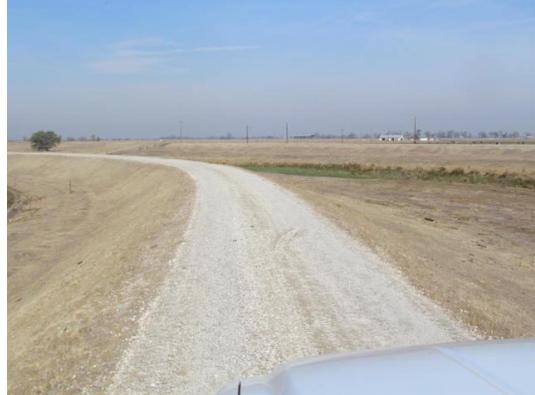
Photo 1 of 2 : SP_2015_NA0010_126_28_20150309_00005.jpg

Looking west at levee crown in complies with standards.

LM Start	0.01	Rating **	A/W	Issue No.	28
LM End	2.22	Issue Type +	Ma	Location *	LS
Category	Earthen Levee		GPS Latitude/Longitude		
			Start	End	
Item	Vegetation		37.253178 °	37.256802 °	
			-120.768513 °	-120.740452 °	
DWR ID	DWR_NA0010_08_s_2012_28				
Action/Comments					
Keep the crown roadway free of vegetation.

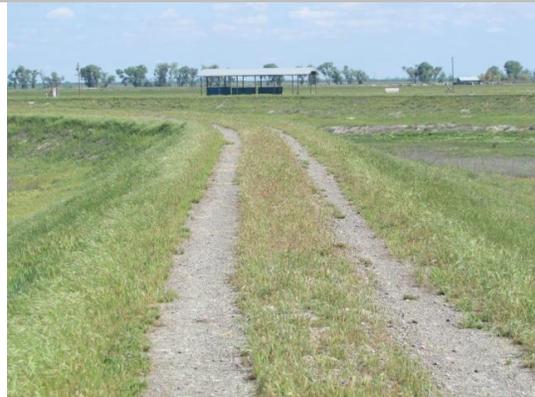
Photo 2 of 2 : SP_2015_NA0010_126_28_20150309_00006.jpg

Looking west at vegetation on levee crown.

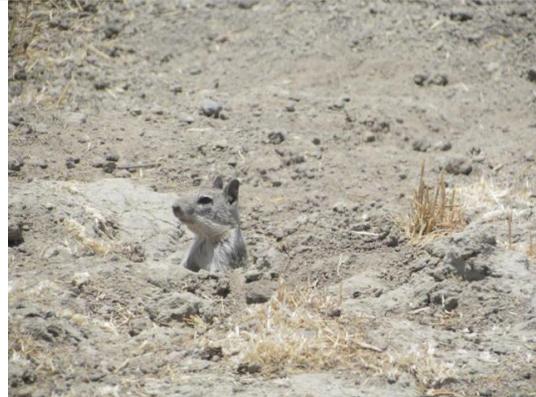
Photo 1 of 1 : SP_2015_NA0010_126_8_20150309_00004.jpg

Looking west at rodent holes on landward slope.

LM Start	1.38	Rating **	M	Issue No.	8
LM End	1.38	Issue Type +	Ma	Location *	LS
Category	Earthen Levee		GPS Latitude/Longitude		
			Start	End	
Item	Animal Control		37.263175 °	37.263175 °	
			-120.752307 °	-120.752307 °	
DWR ID	DWR_NA0010_08_s_2013_8				
Action/Comments					
Exterminate rodents and backfill and compact or grout burrows.

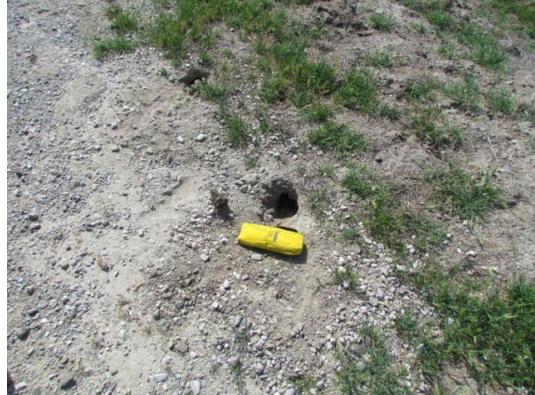
Photo 2 of 4 : SP_2015_NA0010_126_7_20150309_00001.jpg

LM Start	2.07	Rating **	M	Issue No.	7 (cont)
LM End	2.13	Issue Type +	Ma	Location *	LS
Category	Earthen Levee		GPS Latitude/Longitude		
			Start	End	
Item	Animal Control		37.258063 °	37.257688 °	
			-120.742460 °	-120.741573 °	
DWR ID	DWR_NA0010_08_s_2012_7				
Action/Comments					
Exterminate rodents and backfill and compact or grout burrows. Inspector Comments: Several rodent holes were noted on landside slope near drainage pipe. Also noted rodent holes near gate.

Looking at typical rodent hole along the section.

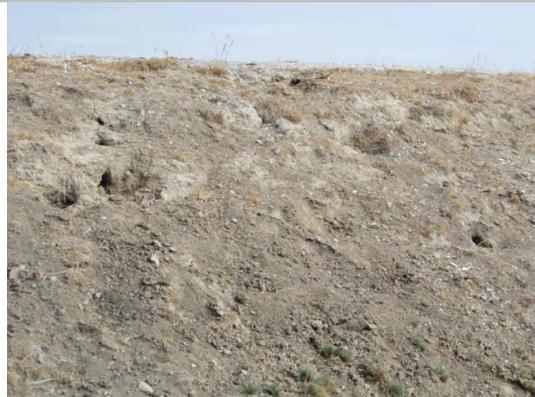
Photo 3 of 4 : SP_2015_NA0010_126_7_20150309_00002.jpg

Looking south at several rodent holes on landward slope.

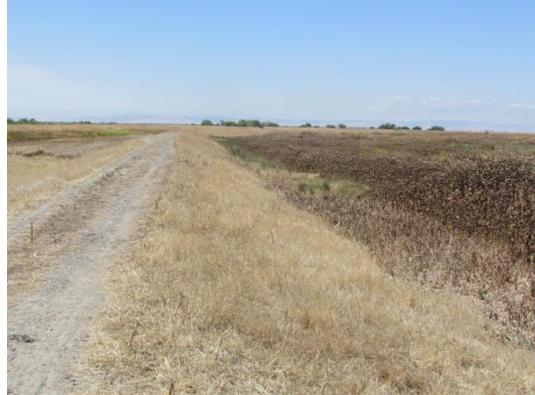
Photo 1 of 1 : SP_2015_NA0010_127_33_20150528_00010.jpg

Looking at typical view of landward slope.

LM Start	0.00	Rating **	A	Issue No.	33
LM End	0.87	Issue Type +	Ma	Location *	LS
Category	Earthen Levee		GPS Latitude/Longitude		
			Start	End	
Item	Vegetation		°	37.220075 °	
			°	-120.698360 °	
DWR ID	DWR_NA0010_09_s_2015_33				
Action/Comments					
Control annual grass and weeds on the levee slopes and easements.

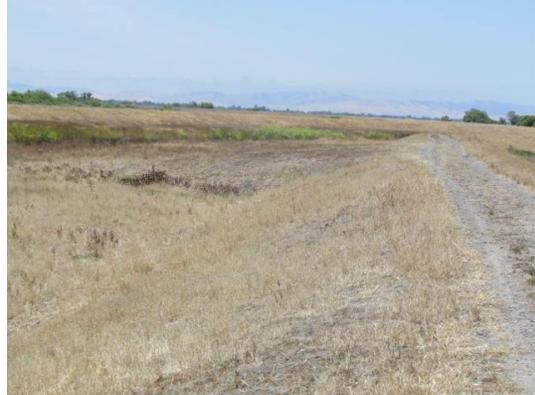
Photo 1 of 1 : SP_2015_NA0010_127_34_20150528_00011.jpg

Looking at typical view of waterward slope.

LM Start	0.00	Rating **	A	Issue No.	34
LM End	0.87	Issue Type +	Ma	Location *	WS
Category	Earthen Levee		GPS Latitude/Longitude		
			Start	End	
Item	Vegetation		°	37.220075 °	
			°	-120.698360 °	
DWR ID	DWR_NA0010_09_s_2015_34				
Action/Comments					
Control annual grass and weeds on the levee slopes and easements.

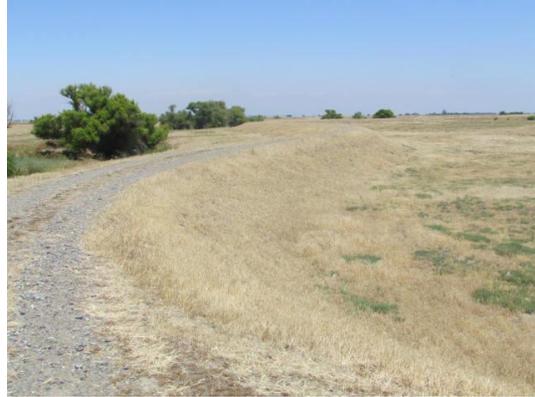
Photo 1 of 1 : SP_2015_NA0010_128_49_20150528_00009.jpg

Looking at typical view of landward slope.

LM Start	0.00	Rating **	M	Issue No.	49
LM End	0.78	Issue Type +	Ma	Location *	LS
Category	Earthen Levee		GPS Latitude/Longitude		
			Start	End	
Item	Vegetation		37.217918 °	37.219343 °	
			-120.711430 °	-120.698195 °	
DWR ID	DWR_NA0010_10_s_2015_49				
Action/Comments					
Control annual grass and weeds on the levee slopes and easements.

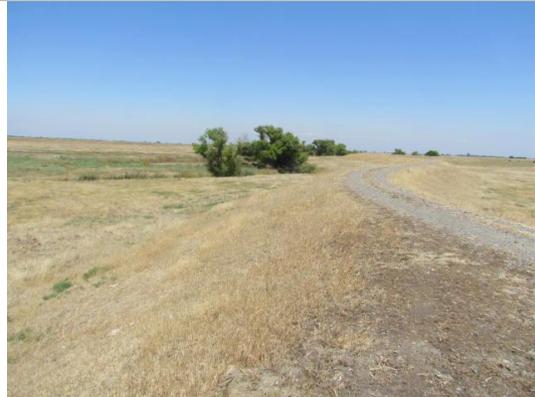
Photo 1 of 1 : SP_2015_NA0010_128_50_20150528_00008.jpg

Looking at typical view of waterward slope.

LM Start	0.00	Rating **	M	Issue No.	50
LM End	0.78	Issue Type +	Ma	Location *	WS
Category	Earthen Levee		GPS Latitude/Longitude		
			Start	End	
Item	Vegetation		37.217918 °	37.219343 °	
			-120.711430 °	-120.698195 °	
DWR ID	DWR_NA0010_10_s_2015_50				
Action/Comments					
Control annual grass and weeds on the levee slopes and easements.

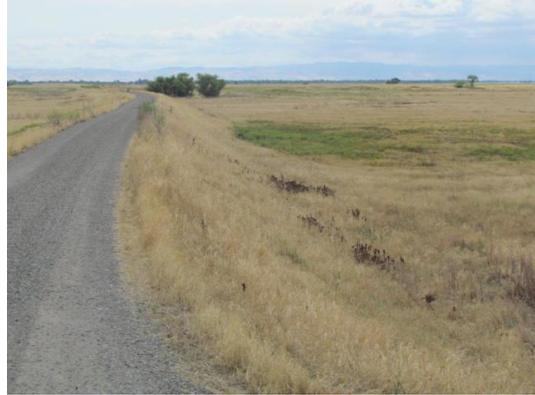
Photo 1 of 1 : SP_2015_NA0010_129_136_20150528_00037.jpg

Looking at typical view of landward slope.

LM Start	0.00	Rating **	M	Issue No.	136
LM End	3.31	Issue Type +	Ma	Location *	LS
Category	Earthen Levee		GPS Latitude/Longitude		
			Start	End	
Item	Vegetation		37.202777 °	37.202333 °	
			-120.755150 °	-120.695280 °	
DWR ID	DWR_NA0010_11_s_2015_136				
Action/Comments					
Control annual grass and weeds on the levee slopes and easements. Inspector Comments: Control growth on landward slope.

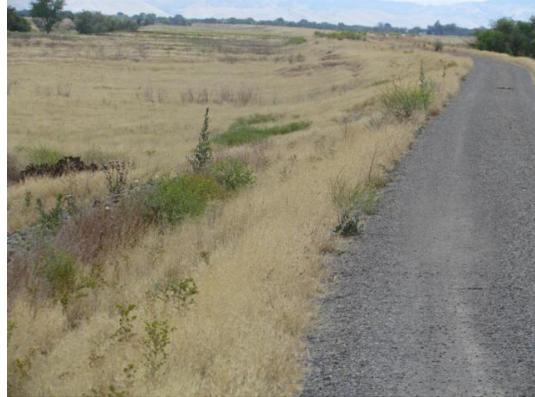
Photo 1 of 1 : SP_2015_NA0010_129_137_20150528_00038.jpg

Looking at typical view of waterward slope.

LM Start	0.00	Rating **	M	Issue No.	137
LM End	3.31	Issue Type +	Ma	Location *	WS
Category	Earthen Levee		GPS Latitude/Longitude		
			Start	End	
Item	Vegetation		37.202778 °	37.202333 °	
			-120.755150 °	-120.695280 °	
DWR ID	DWR_NA0010_11_s_2015_137				
Action/Comments					
Control annual grass and weeds on the levee slopes and easements. Inspector Comments: Control growth on waterward slope.

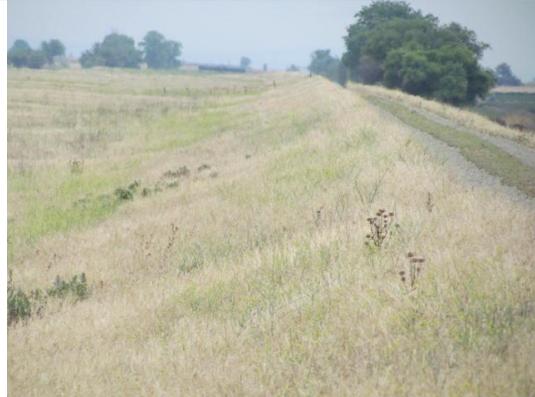
Photo 1 of 1 : SP_2015_NA0010_130_149_20150528_00077.jpg

Looking at typical view of growth on waterward slope.

LM Start	0.00	Rating **	M	Issue No.	149
LM End	3.33	Issue Type +	Ma	Location *	WS
Category	Earthen Levee		GPS Latitude/Longitude		
			Start	End	
Item	Vegetation		37.200935 °		
			-120.755205 °		
DWR ID	DWR_NA0010_12_s_2015_149				
Action/Comments					
Control annual grass and weeds on the levee slopes and easements. Inspector Comments: Control growth on waterward slope.

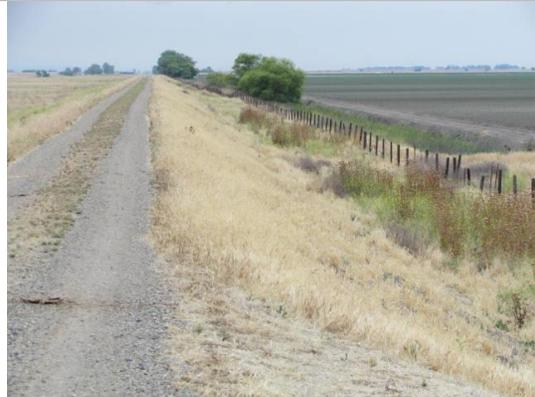
Photo 1 of 1 : SP_2015_NA0010_130_148_20150528_00078.jpg

Looking at typical view of growth on landward slope.

LM Start	0.00	Rating **	M	Issue No.	148
LM End	3.33	Issue Type +	Ma	Location *	LS
Category	Earthen Levee		GPS Latitude/Longitude		
			Start	End	
Item	Vegetation		37.200934 °	37.200959 °	
			-120.755205 °	-120.694810 °	
DWR ID	DWR_NA0010_12_s_2015_148				
Action/Comments					
Control annual grass and weeds on the levee slopes and easements. Inspector Comments: Control growth on landward slope.

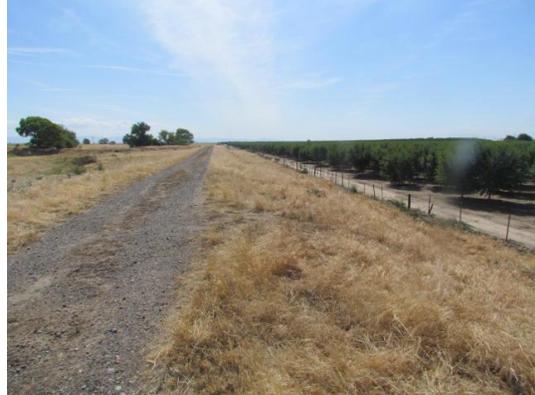
Photo 1 of 1 : SP_2015_NA0010_131_65_20150528_00026.jpg

Looking at typical view of growth on landward slope.

LM Start	0.00	Rating **	M	Issue No.	65
LM End	1.26	Issue Type +	Ma	Location *	LS
Category	Earthen Levee		GPS Latitude/Longitude		
			Start	End	
Item	Vegetation			37.046297 °	
				-120.428123 °	
DWR ID	DWR_NA0010_13_s_2015_65				
Action/Comments					
Control annual grass and weeds on the levee slopes and easements. Inspector Comments: Control growth on landward slope.

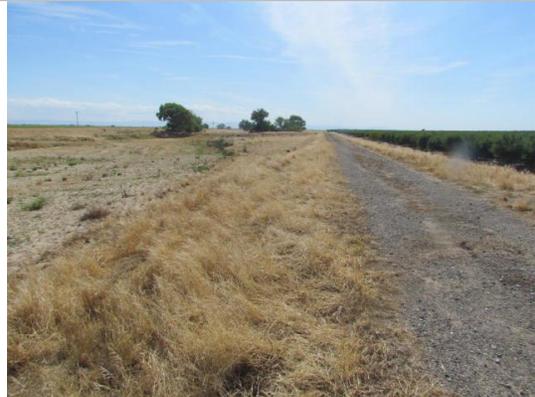
Photo 1 of 1 : SP_2015_NA0010_131_66_20150528_00027.jpg

Looking at typical view of growth on waterward slope.

LM Start	0.00	Rating **	M	Issue No.	66
LM End	1.26	Issue Type +	Ma	Location *	WS
Category	Earthen Levee		GPS Latitude/Longitude		
			Start	End	
Item	Vegetation			37.046297 °	
				-120.428123 °	
DWR ID	DWR_NA0010_13_s_2015_66				
Action/Comments					
Control annual grass and weeds on the levee slopes and easements. Inspector Comments: Control growth on waterward slope.

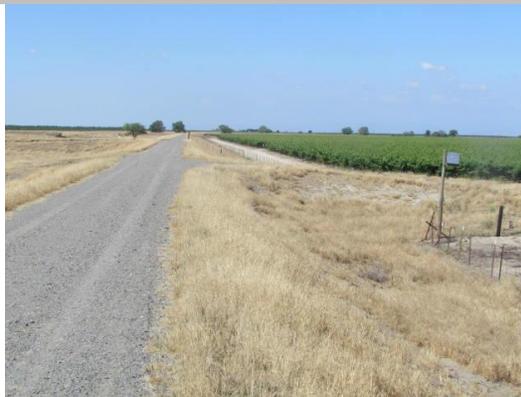
Photo 1 of 1 : SP_2015_NA0010_132_77_20150528_00030.jpg

Looking at typical view of growth on landward slope.

LM Start	0.00	Rating **	M	Issue No.	77
LM End	1.26	Issue Type +	Ma	Location *	LS
Category	Earthen Levee		GPS Latitude/Longitude		
			Start	End	
Item	Vegetation		37.032377 °	37.045398 °	
			-120.441273 °	-120.427757 °	
DWR ID	DWR_NA0010_14_s_2015_77				
Action/Comments					
Remove the wild growth other than native grasses from the levee slopes. Inspector Comments: Control growth on landward slope.

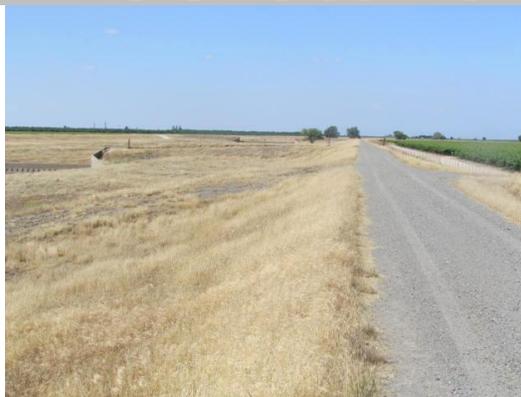
Photo 1 of 1 : SP_2015_NA0010_132_78_20150528_00031.jpg

Looking at typical view of growth on waterward slope.

LM Start	0.00	Rating **	M	Issue No.	78
LM End	1.26	Issue Type +	Ma	Location *	WS
Category	Earthen Levee		GPS Latitude/Longitude		
			Start	End	
Item	Vegetation		37.032377 °	37.045398 °	
			-120.441273 °	-120.427757 °	
DWR ID	DWR_NA0010_14_s_2015_78				
Action/Comments					
Control annual grass and weeds on the levee slopes and easements. Inspector Comments: Control growth on waterward slope.

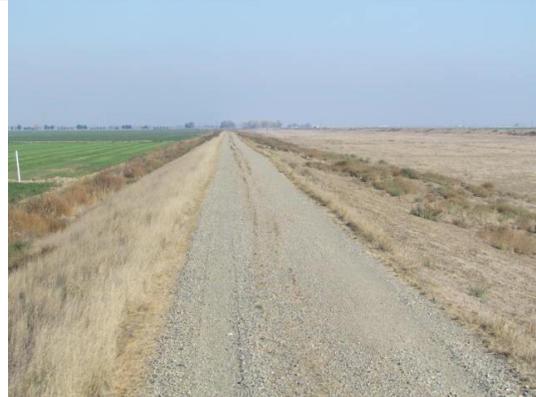
Photo 1 of 2 : SP_2015_NA0010_133_11_20150309_00001.jpg

Looking east at typical view of levee in compliance with standards.

LM Start	0.01	Rating **	A/W	Issue No.	11
LM End	1.99	Issue Type +	Ma	Location *	CR
Category	Earthen Levee		GPS Latitude/Longitude		
			Start	End	
Item	Crown Surface / Depressions / Rutting		36.996547 °	36.996587 °	
			-120.410220 °	-120.374503 °	
DWR ID	DWR_NA0010_15_s_2012_11				
Action/Comments					
Add appropriate material and re-grade the levee to bring the crown above the design elevation. Inspector Comments: Control vegetation on levee crown.

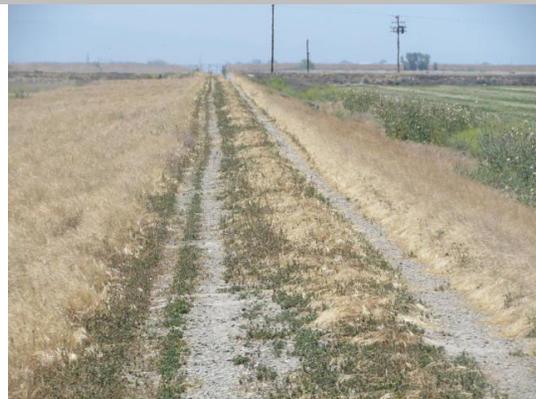
Photo 2 of 2 : SP_2015_NA0010_133_11_20150309_00002.jpg

Looking east at vegetation on levee crown.

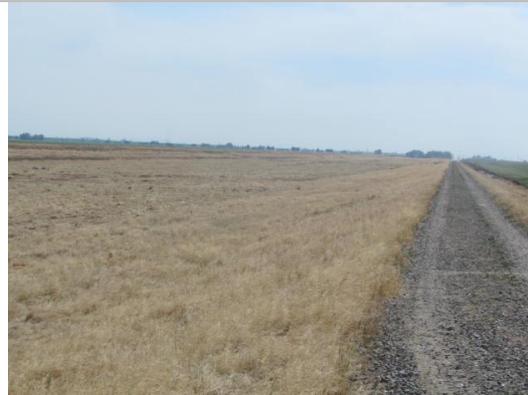
Photo 1 of 1 : SP_2015_NA0010_134_91_20150528_00022.jpg

Looking at typical view of growth on waterward slope.

LM Start	0.00	Rating **	M	Issue No.	91
LM End	1.96	Issue Type +	Ma	Location *	WS
Category	Earthen Levee		GPS Latitude/Longitude		
			Start	End	
Item	Vegetation		36.995349 °	36.995456 °	
			-120.408896 °	-120.383420 °	
DWR ID	DWR_NA0010_16_s_2015_91				
Action/Comments					
Control annual grass and weeds on the levee slopes and easements. Inspector Comments: Control growth on waterward slope.

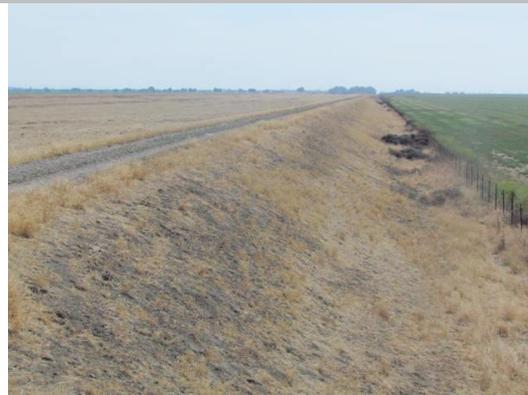
Photo 1 of 1 : SP_2015_NA0010_134_90_20150528_00023.jpg

Looking at typical view of growth on landward slope.

LM Start	0.00	Rating **	M	Issue No.	90
LM End	1.97	Issue Type +	Ma	Location *	LS
Category	Earthen Levee		GPS Latitude/Longitude		
			Start	End	
Item	Vegetation		36.995349 °	36.995457 °	
			-120.408896 °	-120.383420 °	
DWR ID	DWR_NA0010_16_s_2015_90				
Action/Comments					
Control annual grass and weeds on the levee slopes and easements. Inspector Comments: Control growth on landward slope.

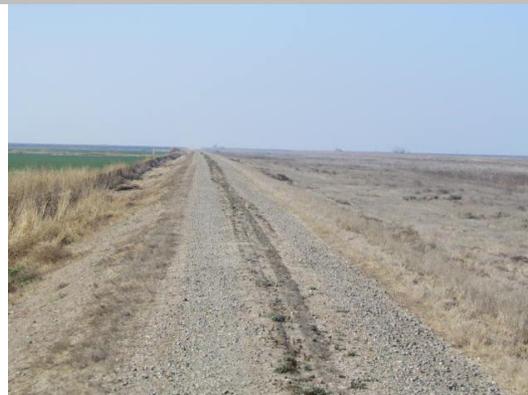
Photo 1 of 1 : SP_2015_NA0010_134_14_20150309_00003.jpg

LM Start	0.01	Rating **	A/W	Issue No.	14
LM End	1.96	Issue Type +	Ma	Location *	CR
Category	Earthen Levee		GPS Latitude/Longitude		
			Start	End	
Item	Crown Surface / Depressions / Rutting		36.995388 °	36.995507 °	
			-120.408738 °	-120.373592 °	
DWR ID	DWR_NA0010_16_s_2012_14				
Action/Comments					
Add appropriate material and re-grade the levee to bring the crown above the design elevation. Inspector Comments: Control vegetation on levee crown.

Looking west at the properly maintained levee crown.

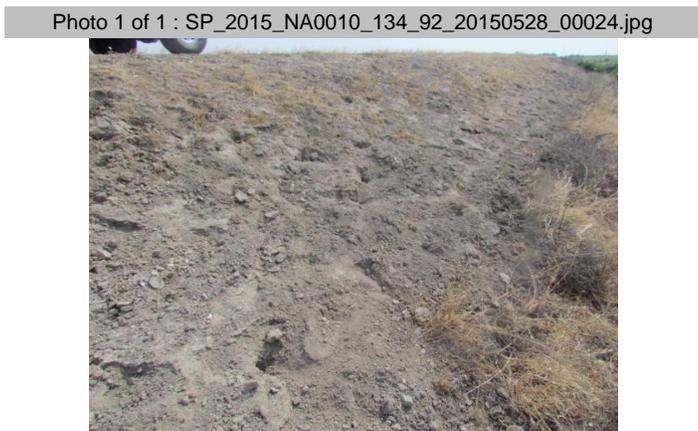
LM Start	0.93	Rating **	M	Issue No.	92
LM End	0.93	Issue Type +	Ma	Location *	LS
Category	Earthen Levee		GPS Latitude/Longitude		
			Start	End	
Item	Animal Control		36.995439 °	36.995439 °	
			-120.392146 °	-120.392146 °	
DWR ID	DWR_NA0010_16_s_2015_92				
Action/Comments					
No rodents visible, but rodent burrows visible; need to backfill and compact or grout burrows. Inspector Comments: Notice several rodent holes within this section.

Looking at several rodent holes on landward slope.
