**Flood Control Project Maintenance
Levee Inspections**

Maintenance Issue Types Only, Levee Inspection Report By Mile - Spring 2015

Lower San Joaquin Levee District

Waterway	Bank	Unit Miles	Inspection Start/End	Inspector
Unit No. 01 San Joaquin River	Right	22.52	05/18/2015 05/22/2015	Richard Willoughby

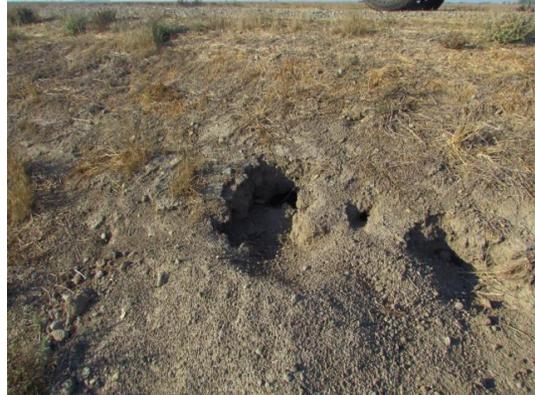
Photo 1 of 2 : SP_2015_NA0010_134_2_20150309_00001.jpg

LM Start	1.77	Rating **	M	Issue No.	2
LM End	1.77	Issue Type +	Ma	Location *	LS
Category	Earthen Levee			GPS Latitude/Longitude	
				Start	End
Item	Animal Control			36.995487 °	36.995487 °
				-120.377054 °	-120.377054 °
DWR ID	DWR_NA0010_16_f_2014_2				
Action/Comments					
No rodents visible, but rodent burrows visible; need to backfill and compact or grout burrows. Inspector Comments: Large rodent holes on landward slope.

Looking at large rodent holes on landward slope.

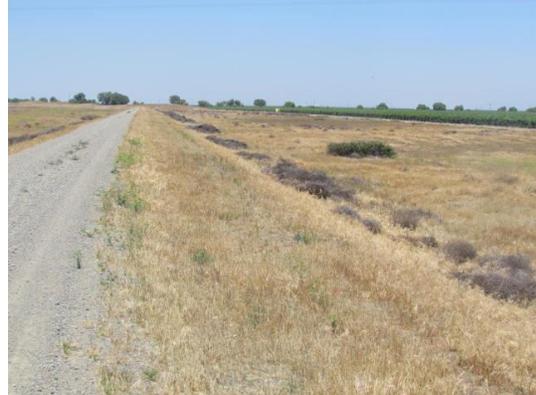
Photo 1 of 1 : SP_2015_NA0010_135_11_20150528_00112.jpg

LM Start	0.00	Rating **	M	Issue No.	11
LM End	16.09	Issue Type +	Ma	Location *	LS
Category	Earthen Levee		GPS Latitude/Longitude		
			Start	End	
Item	Vegetation			°	°
				°	°
DWR ID	DWR_NA0010_17_f_2014_11				
Action/Comments					
Control annual grass and weeds on the levee slopes and easements. Inspector Comments: Control growth on landward slope.

Looking at typical view of growth on landward slope.

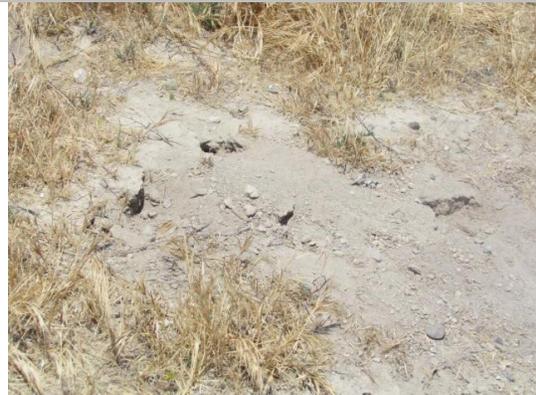
Photo 1 of 2 : SP_2015_NA0010_135_8_20150528_00114.jpg

LM Start	5.75	Rating **	M	Issue No.	8
LM End	5.90	Issue Type +	Ma	Location *	LS
Category	Earthen Levee		GPS Latitude/Longitude		
			Start	End	
Item	Animal Control		36.908605	°	36.906507
			-120.331112	°	-120.330353
DWR ID	DWR_NA0010_17_s_2012_8				
Action/Comments					
Exterminate rodents and backfill and compact or grout burrows. Inspector Comments: Several rodent holes noted on landward slope.

Looking at several rodent holes on landward slope. (Spring 2015)

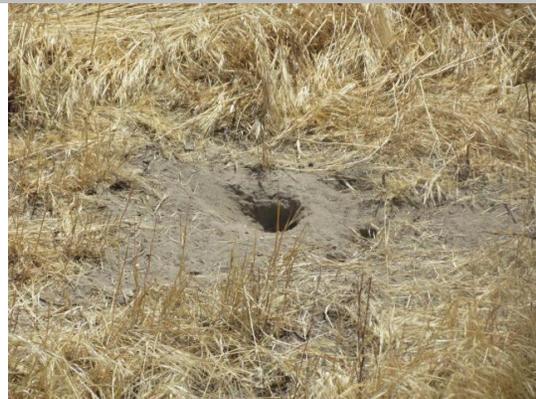
Photo 1 of 1 : SP_2015_NA0010_135_4_20150528_00115.jpg

LM Start	6.51	Rating **	M	Issue No.	4
LM End	6.60	Issue Type +	Ma	Location *	LS
Category	Earthen Levee			GPS Latitude/Longitude	
				Start	End
Item	Animal Control			36.898124 °	36.896943 °
				-120.326714 °	-120.326133 °
DWR ID	DWR_NA0010_17_s_2012_4				
Action/Comments					
Exterminate rodents and backfill and compact or grout burrows. Inspector Comments: Notice several rodent holes within this reach.

Looking at typical view of rodent holes on landward slope.

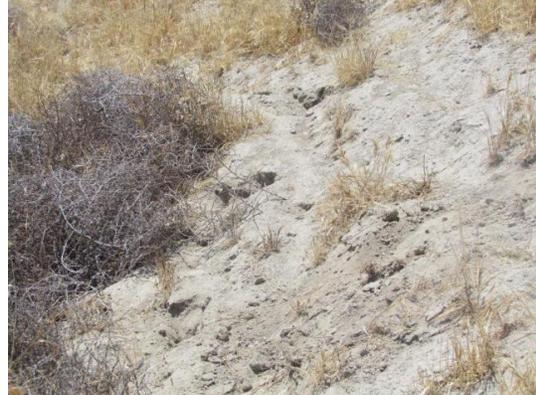
Photo 1 of 1 : SP_2015_NA0010_135_3_20150528_00117.jpg

LM Start	12.34	Rating **	M	Issue No.	3
LM End	12.37	Issue Type +	Ma	Location *	LS
Category	Earthen Levee		GPS Latitude/Longitude		
			Start	End	
Item	Animal Control		36.820558 °	36.820155 °	
			-120.300616 °	-120.300784 °	
DWR ID	DWR_NA0010_17_s_2014_3				
Action/Comments					
No rodents visible, but rodent burrows visible; need to backfill and compact or grout burrows. Inspector Comments: Noted several rodent holes with this reach.

Looking at several rodent holes on landward slope.

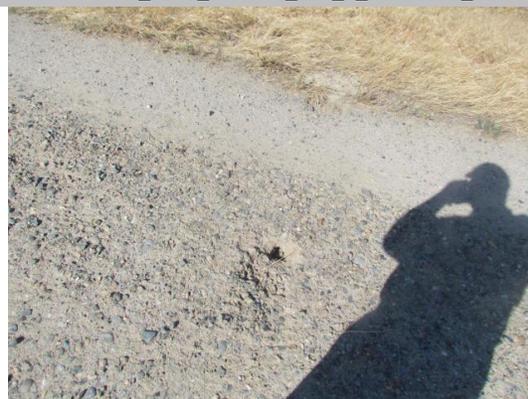
Photo 1 of 1 : SP_2015_NA0010_137_7_20150528_00044.jpg

LM Start	1.44	Rating **	M	Issue No.	7
LM End	1.44	Issue Type +	Ma	Location *	LS
Category	Earthen Levee		GPS Latitude/Longitude		
			Start	End	
Item	Animal Control		36.956163 °	36.956163 °	
			-120.353672 °	-120.353672 °	
DWR ID	DWR_NA0010_18_s_2014_7				
Action/Comments					
No rodents visible, but rodent burrows visible; need to backfill and compact or grout burrows. Inspector Comments: Several noted on landward slope and on levee crown.

Looking at typical view of rodent holes within this section on landward slope.

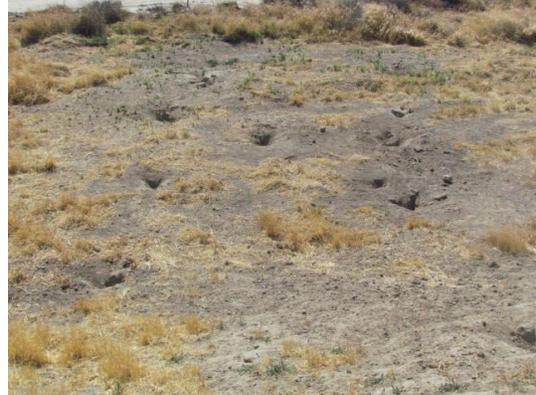
Photo 1 of 1 : SP_2015_NA0010_137_1_20150528_00048.jpg

LM Start	5.89	Rating **	M	Issue No.	1
LM End	5.89	Issue Type +	Ma	Location *	LS
Category	Earthen Levee		GPS Latitude/Longitude		
			Start	End	
Item	Animal Control		36.895175 °	36.895175 °	
			-120.327632 °	-120.327632 °	
DWR ID	DWR_NA0010_18_s_2015_1				
Action/Comments					
No rodents visible, but rodent burrows visible; need to backfill and compact or grout burrows. Inspector Comments: Several large rodent holes noted on landward slope and berm within this section.

Looking at several rodent holes on landward slope.

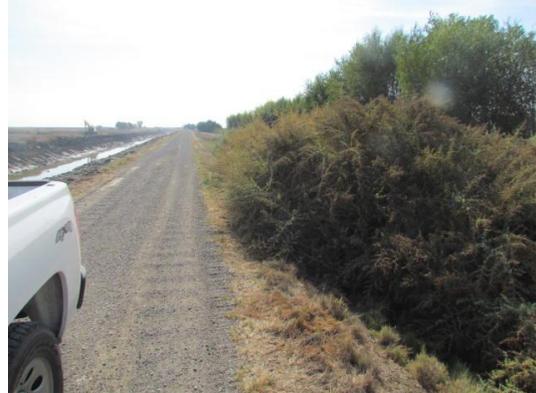
Photo 1 of 1 : SP_2015_NA0010_138_21_20150309_00011.jpg

LM Start	0.53	Rating **	M	Issue No.	21
LM End	0.53	Issue Type +	Ma	Location *	LS
Category	Earthen Levee			GPS Latitude/Longitude	
				Start	End
Item	Vegetation			37.213006 °	37.213006 °
				-120.698019 °	-120.698019 °
DWR ID	DWR_NA0010_22A_f_2014_21				
Action/Comments					
Remove the wild growth other than native grasses from the levee slopes. Inspector Comments: Dense brush on landward slope.

Looking south at dense brushes on landward slope.

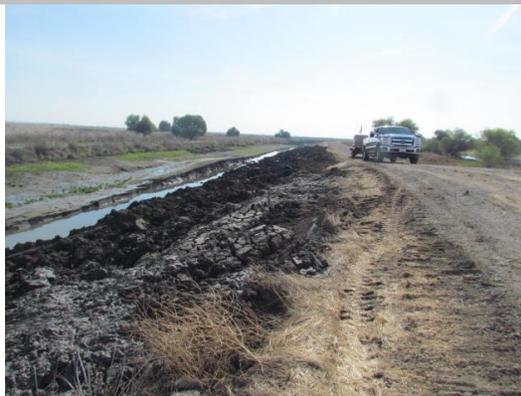
Photo 1 of 3 : SP_2015_NA0010_138_22_20150309_00012.jpg

LM Start	0.96	Rating **	A/W	Issue No.	22
LM End	0.96	Issue Type +	Ma	Location *	WS
Category	Earthen Levee			GPS Latitude/Longitude	
				Start	End
Item	Slope Stability			37.219137 °	37.219137 °
				-120.697857 °	-120.697857 °
DWR ID	DWR_NA0010_22A_f_2014_22				
Action/Comments					
Repair slope instability. Inspector Comments: Irrigation district excavated waterward slope.

Looking south at excavated waterward slope.

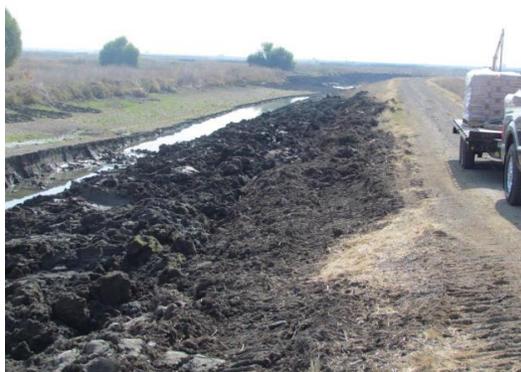
Photo 2 of 3 : SP_2015_NA0010_138_22_20150309_00013.jpg

LM Start	0.96	Rating **	A/W	Issue No.	22 (cont)
LM End	0.96	Issue Type +	Ma	Location *	WS

Looking southeast at excavated waterward slope.

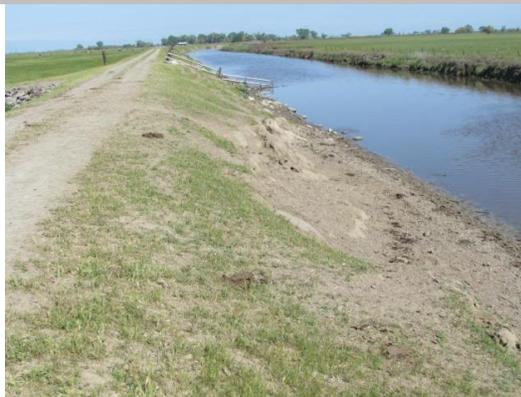
Photo 2 of 2 : SP_2015_NA0010_138_5_20150309_00007.jpg

LM Start	4.79	Rating **	A/W	Issue No.	5 (cont)
LM End	4.86	Issue Type +	Ma	Location *	WS
Category	Earthen Levee			GPS Latitude/Longitude	
				Start	End
Item	Animal Control			37.265180 °	37.265743 °
				-120.732745 °	-120.733602 °
DWR ID	DWR_NA0010_22A_s_2012_5				
Action/Comments					
Repair the levee slope damaged by livestock and prevent large animal access. Inspector Comments: Erosion sites repaired by LMA on waterward toe.

Looking north at waterside erosion from livestock. (Fall 2014)

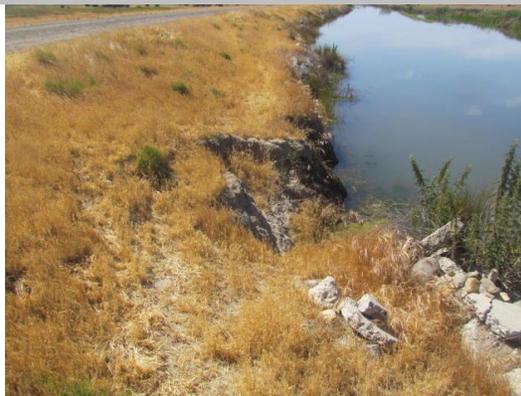
Photo 1 of 1 : SP_2015_NA0010_138_12_20150309_00010.jpg

LM Start	5.03	Rating **	M	Issue No.	12
LM End	5.03	Issue Type +	Ma	Location *	WS
Category	Earthen Levee			GPS Latitude/Longitude	
				Start	End
Item	Slope Stability			37.267271 °	37.267271 °
				-120.736067 °	-120.736067 °
DWR ID	DWR_NA0010_22A_s_2014_12				
Action/Comments					
Repair the levee slope damaged by foot traffic and prevent access where possible. Inspector Comments: Slope damage caused by animal traffic.

Looking south at slope damage cause by animal traffic on waterside slope.

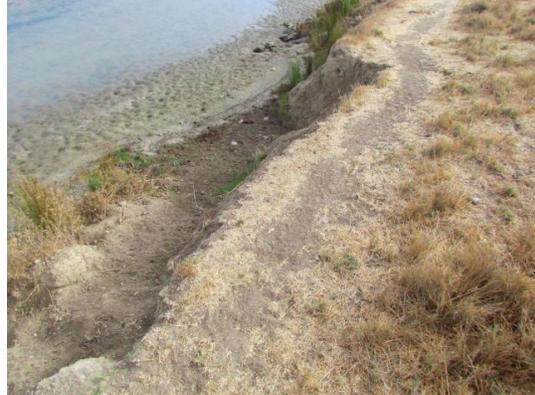
Photo 1 of 2 : SP_2015_NA0010_138_4_20150309_00005.jpg

LM Start	5.05	Rating **	M	Issue No.	4
LM End	5.05	Issue Type +	Ma	Location *	WS
Category	Earthen Levee		GPS Latitude/Longitude		
			Start	End	
Item	Erosion / Bank Caving		37.267516 °	37.267516 °	
			-120.736401 °	-120.736401 °	
DWR ID	DWR_NA0010_22A_f_2013_4				
Action/Comments					
Schedule repair of erosion site prior to the next inspection. Inspector Comments: Erosion caused by animal traffic.

Looking southeast at livestock erosion on waterward toe.

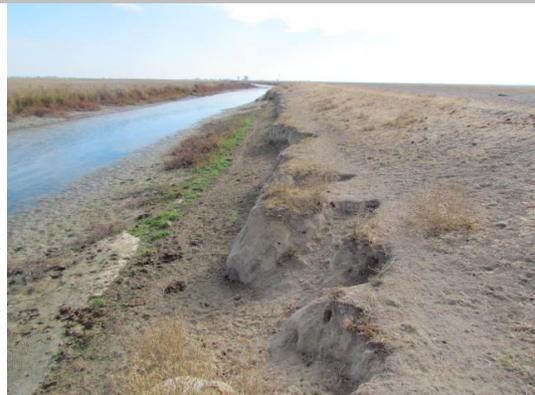
Photo 1 of 2 : SP_2015_NA0010_138_6_20150309_00008.jpg

LM Start	5.14	Rating **	M	Issue No.	6
LM End	5.20	Issue Type +	Ma	Location *	WS
Category	Earthen Levee		GPS Latitude/Longitude		
			Start	End	
Item	Animal Control		37.268492 °	37.269133 °	
			-120.737493 °	-120.738208 °	
DWR ID	DWR_NA0010_22A_s_2012_6				
Action/Comments					
Repair the levee slope damaged by livestock and prevent large animal access. Inspector Comments: Erosion caused by livestock on waterside toe.

Looking south at livestock erosion on waterward toe.

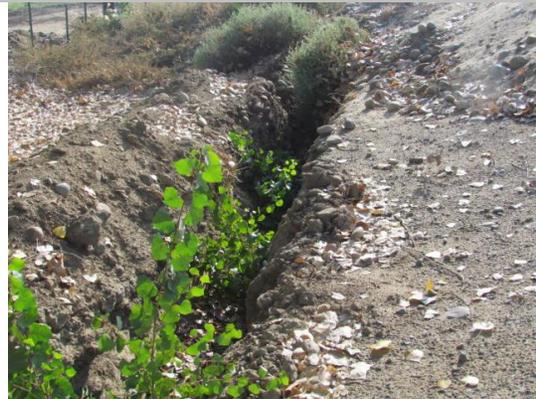
Photo 2 of 3 : SP_2015_NA0010_139_29_20150309_00015.jpg

LM Start	1.53	Rating **	M	Issue No.	29
LM End	1.53	Issue Type +	Ma	Location *	LS
Category	Earthen Levee		GPS Latitude/Longitude		
			Start	End	
Item	Slope Stability		36.772041 °	36.772041 °	
			-120.259549 °	-120.259549 °	
DWR ID	DWR_NA0010_23_f_2014_29				
Action/Comments					
Repair slope instability. Inspector Comments: Trench at landward toe. Trench is ten to twelve inches wide and twenty feet long.

Looking south at trench at landward toe.

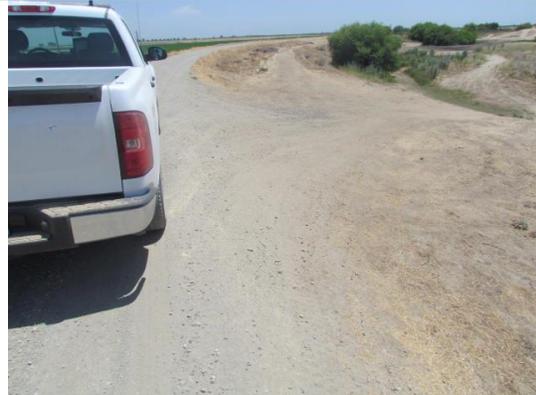
Photo 1 of 1 : SP_2015_NA0010_139_16_20150309_00012.jpg

LM Start	2.12	Rating **	M	Issue No.	16
LM End	2.42	Issue Type +	Ma	Location *	WS
Category	Earthen Levee		GPS Latitude/Longitude		
			Start	End	
Item	Slope Stability		36.775507 °	36.774423 °	
			-120.251672 °	-120.246993 °	
DWR ID	DWR_NA0010_23_s_2013_16				
Action/Comments					
Repair the levee slope damaged by vehicle traffic and prevent access where possible. Inspector Comments: Several damaged sites within this reach. Damage caused by vehicle traffic.

Looking south at waterward slope damaged by vehicle traffic

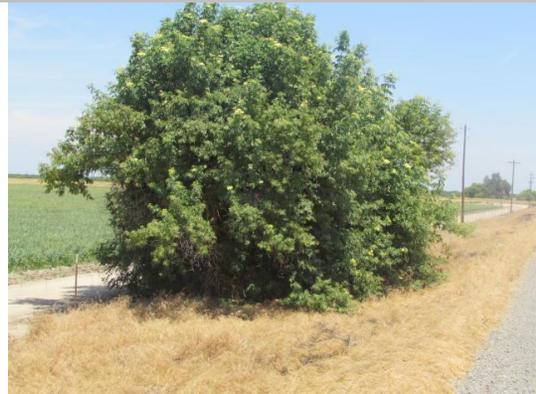
Photo 1 of 2 : SP_2015_NA0010_139_15_20150528_00116.jpg

LM Start	2.85	Rating **	M	Issue No.	15
LM End	2.85	Issue Type +	Ma	Location *	LS
Category	Earthen Levee		GPS Latitude/Longitude		
			Start	End	
Item	Vegetation		36.771537 °	36.771537 °	
			-120.240917 °	-120.240917 °	
DWR ID	DWR_NA0010_23_s_2012_15				
Action/Comments					
Elderberries are blocking visibility and flood fight capability. Inspector Comments: Control growth of elderberry bush on landward toe.

Looking south at elderberry at landward toe. (Spring 2015)

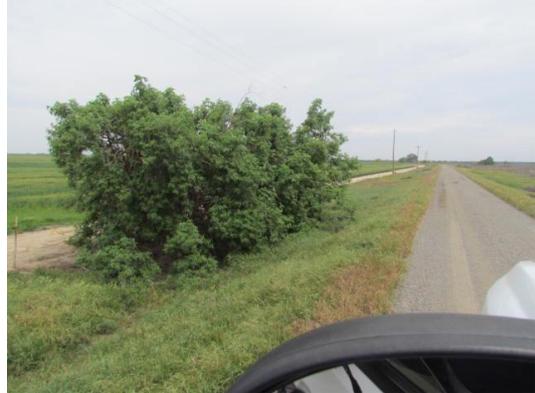
Photo 2 of 2 : SP_2015_NA0010_139_15_20150309_00011.jpg

LM Start	2.85	Rating **	M	Issue No.	15 (cont)
LM End	2.85	Issue Type +	Ma	Location *	LS
Category	Earthen Levee		GPS Latitude/Longitude		
			Start	End	
Item	Vegetation		36.771537 °	36.771537 °	
			-120.240917 °	-120.240917 °	
DWR ID	DWR_NA0010_23_s_2012_15				
Action/Comments					
Elderberries are blocking visibility and flood fight capability. Inspector Comments: Control growth of elderberry bush on landward toe.

Looking south at elderberry on landside toe and berm. (Fall 2014)

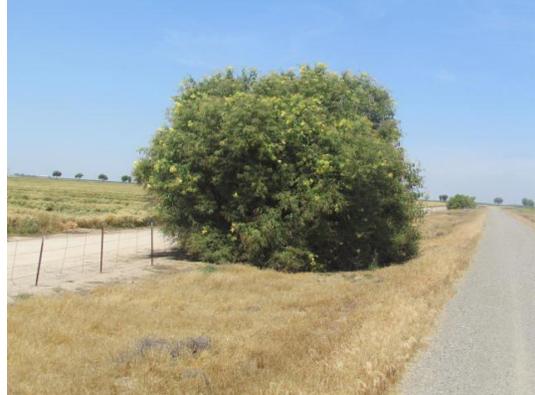
Photo 1 of 3 : SP_2015_NA0010_139_3_20150528_00117.jpg

LM Start	3.30	Rating **	M	Issue No.	3
LM End	3.30	Issue Type +	Ma	Location *	LS
Category	Earthen Levee		GPS Latitude/Longitude		
			Start	End	
Item	Vegetation		36.774403 °	36.774403 °	
			-120.234705 °	-120.234705 °	
DWR ID	DWR_NA0010_23_s_2012_3				
Action/Comments					
Elderberries are blocking visibility and flood fight capability. Inspector Comments: Control growth of elderberry on landward toe.

Looking south at elderberry on landward toe and berm. (Spring 2015)

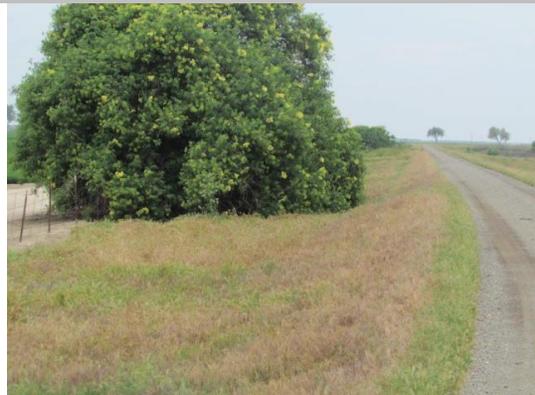
Photo 2 of 3 : SP_2015_NA0010_139_3_20150309_00002.jpg

Looking south at elderberry on landside toe and berm. (Fall 2014)

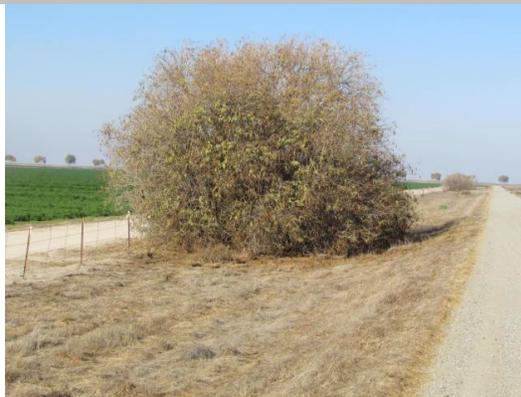
Photo 3 of 3 : SP_2015_NA0010_139_3_20150309_00001.jpg

LM Start	3.30	Rating **	M	Issue No.	3 (cont)
LM End	3.30	Issue Type +	Ma	Location *	LS
Category	Earthen Levee		GPS Latitude/Longitude		
			Start	End	
Item	Vegetation		36.774403 °	36.774403 °	
			-120.234705 °	-120.234705 °	
DWR ID	DWR_NA0010_23_s_2012_3				
Action/Comments					
Elderberries are blocking visibility and flood fight capability. Inspector Comments: Control growth of elderberry on landward toe.

Looking south at elderberry bush on landward toe. (Spring 2013)

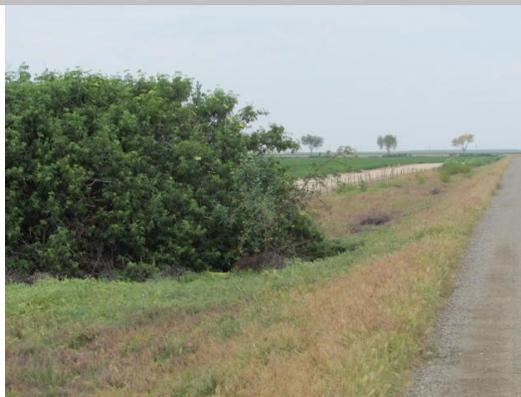
Photo 1 of 1 : SP_2015_NA0010_139_9_20150309_00004.jpg

LM Start	3.45	Rating **	M	Issue No.	9
LM End	3.45	Issue Type +	Ma	Location *	LS
Category	Earthen Levee		GPS Latitude/Longitude		
			Start	End	
Item	Vegetation		36.776537 °	36.776537 °	
			-120.234573 °	-120.234573 °	
DWR ID	DWR_NA0010_23_s_2012_9				
Action/Comments					
Elderberries are blocking visibility and flood fight capability. Inspector Comments: Control growth of elderberry on landward toe and berm.

Looking south at elderberry on landside toe and berm.

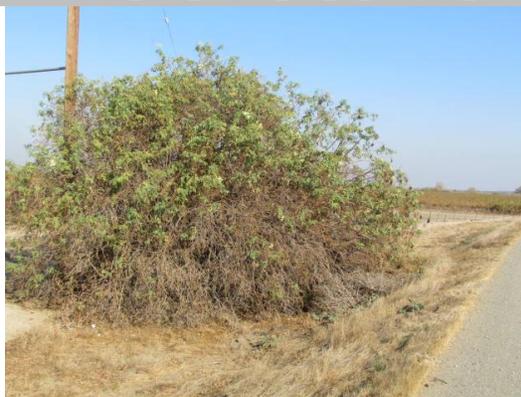
Photo 1 of 2 : SP_2015_NA0010_139_10_20150309_00005.jpg

LM Start	4.13	Rating **	M	Issue No.	10
LM End	4.13	Issue Type +	Ma	Location *	LS
Category	Earthen Levee		GPS Latitude/Longitude		
			Start	End	
Item	Vegetation		36.784212 °	36.784212 °	
			-120.228815 °	-120.228815 °	
DWR ID	DWR_NA0010_23_s_2012_10				
Action/Comments					
Elderberries are blocking visibility and flood fight capability. Inspector Comments: Control growth of elderberry on landward toe.

Looking south at elderberry bush on landward toe. (Fall 2013)

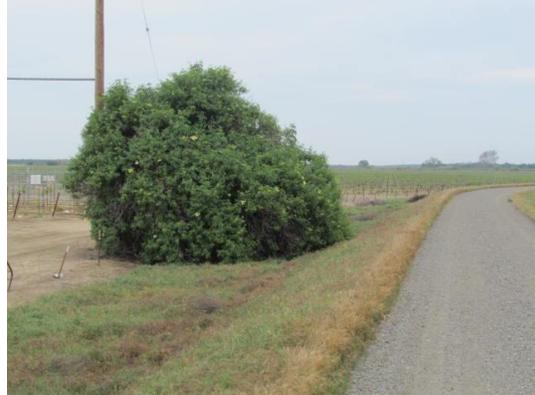
Photo 2 of 2 : SP_2015_NA0010_139_10_20150309_00006.jpg

LM Start	4.13	Rating **	M	Issue No.	10 (cont)
LM End	4.13	Issue Type +	Ma	Location *	LS
Category	Earthen Levee		GPS Latitude/Longitude		
			Start	End	
Item	Vegetation		36.784212 °	36.784212 °	
			-120.228815 °	-120.228815 °	
DWR ID	DWR_NA0010_23_s_2012_10				
Action/Comments					
Elderberries are blocking visibility and flood fight capability. Inspector Comments: Control growth of elderberry on landward toe.

Looking south at elderberry on landside toe and berm.

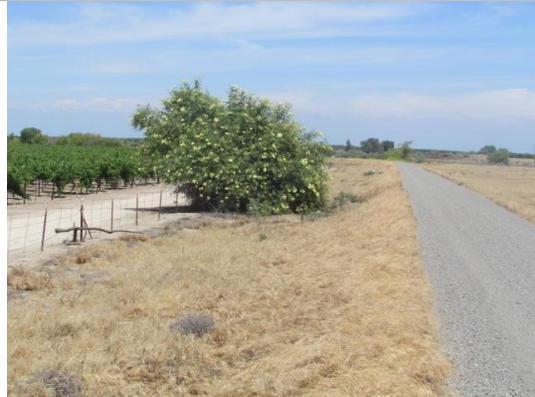
Photo 1 of 2 : SP_2015_NA0010_139_11_20150528_00118.jpg

LM Start	4.45	Rating **	M	Issue No.	11
LM End	4.45	Issue Type +	Ma	Location *	LS
Category	Earthen Levee		GPS Latitude/Longitude		
			Start	End	
Item	Vegetation		36.784523 °	36.784523 °	
			-120.223292 °	-120.223292 °	
DWR ID	DWR_NA0010_23_s_2012_11				
Action/Comments					
Elderberries are blocking visibility and flood fight capability. Inspector Comments: Control growth of elderberry on landward toe and berm.

Looking south at elderberry on landward toe and berm. (Spring 2015)

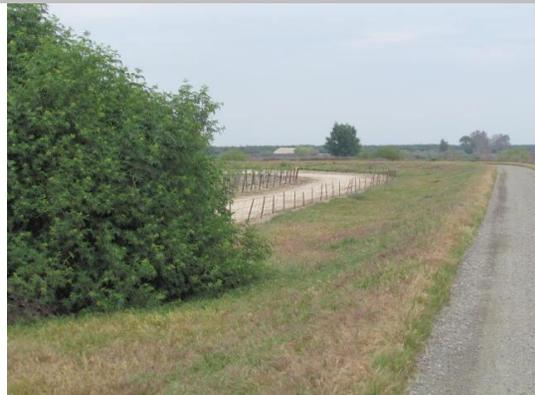
Photo 2 of 2 : SP_2015_NA0010_139_11_20150309_00007.jpg

Looking south at elderberry on landside toe and berm.

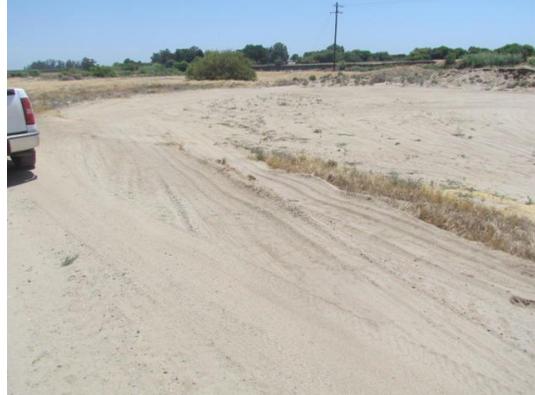
Photo 1 of 1 : SP_2015_NA0010_139_17_20150309_00013.jpg

LM Start	8.47	Rating **	A/W	Issue No.	17
LM End	8.47	Issue Type +	Ma	Location *	WS
Category	Earthen Levee		GPS Latitude/Longitude		
			Start	End	
Item	Slope Stability		36.793717 °	36.793717 °	
			-120.178997 °	-120.178997 °	
DWR ID	DWR_NA0010_23_s_2015_17				
Action/Comments					
Repair the levee slope damaged by vehicle traffic and prevent access where possible. Inspector Comments: Waterward slope.

Looking southwest at waterward slope damaged due to vehicle traffic.

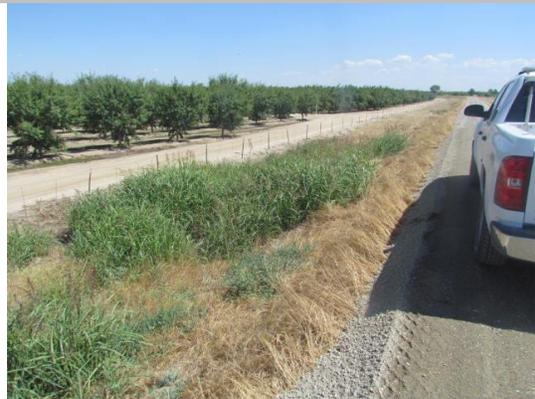
Photo 1 of 1 : SP_2015_NA0010_140_268_20150528_00071.jpg

LM Start	4.50	Rating **	M	Issue No.	268
LM End	4.50	Issue Type +	Ma	Location *	LS
Category	Earthen Levee		GPS Latitude/Longitude		
			Start	End	
Item	Vegetation		36.775118 °	36.775118 °	
			-120.231114 °	-120.231114 °	
DWR ID	DWR_NA0010_24_s_2015_268				
Action/Comments					
Remove the wild growth other than native grasses from the levee slopes. Inspector Comments: Control Johnson Grass on landward toe and berm.

Looking south at Johnson Grass at landward toe and berm.

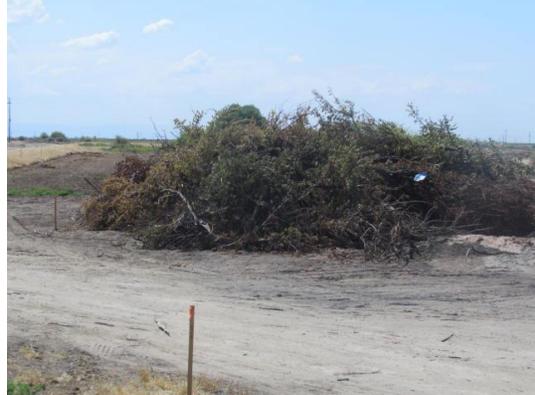
Photo 1 of 3 : SP_2015_NA0010_140_3_20150528_00073.jpg

LM Start	6.33	Rating **	M	Issue No.	3
LM End	6.33	Issue Type +	Ma	Location *	WS
Category	Earthen Levee		GPS Latitude/Longitude		
			Start	End	
Item	Encroachments		36.788155 °	36.788155 °	
			-120.209655 °	-120.209655 °	
DWR ID	DWR_NA0010_24_s_2012_3				
Action/Comments					
Prunings Inspector Comments: Large pruning pile in channel.

Looking northeast at pruning pile on waterward berm. (Spring 2015)

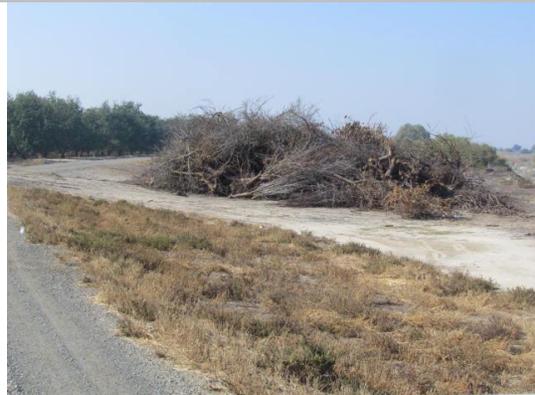
Photo 2 of 3 : SP_2015_NA0010_140_3_20150309_00001.jpg

Looking north at large pruning pile in channel. (Spring 2014)

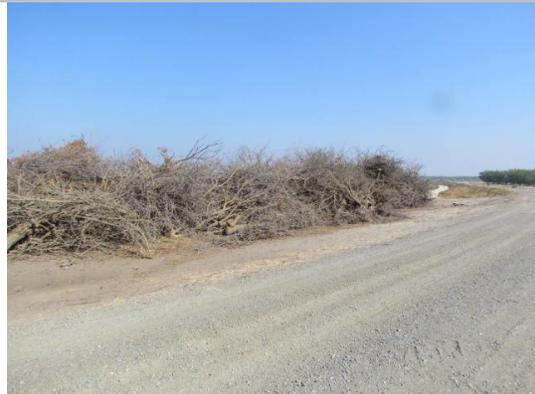
Photo 3 of 3 : SP_2015_NA0010_140_3_20150309_00002.jpg

Looking south at large pruning pile in channel. (Spring 2013)

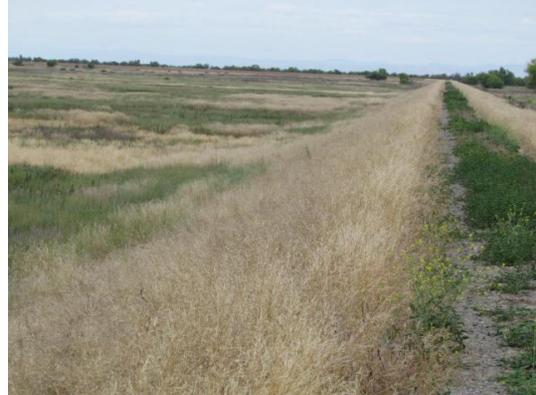
Photo 1 of 1 : SP_2015_NA0010_141_48_20150528_00003.jpg

LM Start	0.00	Rating **	U	Issue No.	48
LM End	2.49	Issue Type +	Ma	Location *	LS
Category	Earthen Levee		GPS Latitude/Longitude		
			Start	End	
Item	Vegetation		37.296314 °	37.271098 °	
			-120.880559 °	-120.866570 °	
DWR ID	DWR_NA0010_25_s_2015_48				
Action/Comments					
Control annual grass and weeds on the levee slopes and easements. Inspector Comments: Control dense growth on waterward slope. Vegetation blocking view of slope.

Looking north at dense growth on landward slope.

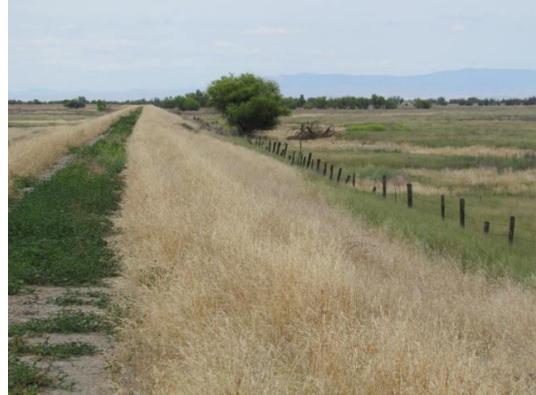
Photo 1 of 1 : SP_2015_NA0010_141_49_20150528_00004.jpg

LM Start	0.00	Rating **	U	Issue No.	49
LM End	2.49	Issue Type +	Ma	Location *	WS
Category	Earthen Levee		GPS Latitude/Longitude		
			Start	End	
Item	Vegetation		37.296314 °	37.271097 °	
			-120.880559 °	-120.866570 °	
DWR ID	DWR_NA0010_25_s_2015_49				
Action/Comments					
Control annual grass and weeds on the levee slopes and easements. Inspector Comments: Control dense growth on landward slope. Vegetation blocking view of slope.

Looking north at dense growth on waterward slope.

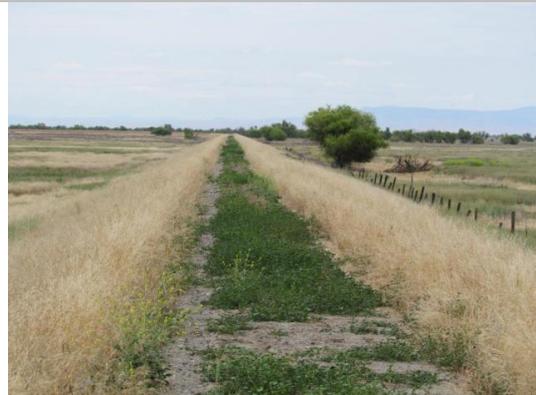
Photo 1 of 1 : SP_2015_NA0010_141_8_20150528_00005.jpg

LM Start	0.01	Rating **	M	Issue No.	8
LM End	2.48	Issue Type +	Ma	Location *	CR
Category	Earthen Levee		GPS Latitude/Longitude		
			Start	End	
Item	Crown Surface / Depressions / Rutting		37.296117 °	37.271193 °	
			-120.880724 °	-120.866633 °	
DWR ID	DWR_NA0010_25_s_2012_8				
Action/Comments					
Add appropriate material and re-grade the levee to bring the crown above the design elevation. Inspector Comments: Control weeds on levee crown.

Looking north at growth on levee crown.
