**Flood Control Project Maintenance  
Levee Inspections**

**Maintenance Issue Types Only, Levee Inspection Report By Mile - Spring 2016**

**Lower San Joaquin Levee District**

Waterway	Bank	Unit Miles	Inspection Start/End	Inspector
Unit No. 01 San Joaquin River	Right	22.52	05/16/2016 05/19/2016	Richard Willoughby

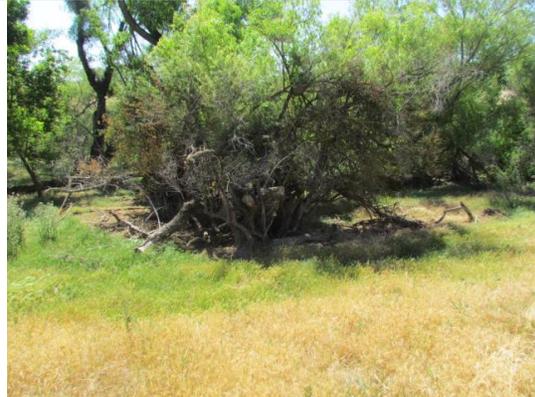
Photo 1 of 1 : SP\_2016\_NA0010\_118\_3\_20160523\_00233.jpg

LM Start	<b>0.19</b>	Rating **	M	Issue No.	<b>3</b>
LM End	<b>0.19</b>	Issue Type +	Ma	Location *	LS
Category	Earthen Levee		GPS Latitude/Longitude		
			Start	End	
Item	Trim / Thin Trees		37.346576 °	37.346576 °	
			-120.961061 °	-120.961061 °	
DWR ID	DWR_NA0010_01_s_2016_3				
Comment Code					
T2 : Thin trees to allow visibility of the ground and room to flood fight.					
Inspector Comment					
Dead tree (limbs & branches) blocking landward right of way/ berm.

Looking east at brush and tree limbs blocking landward toe.

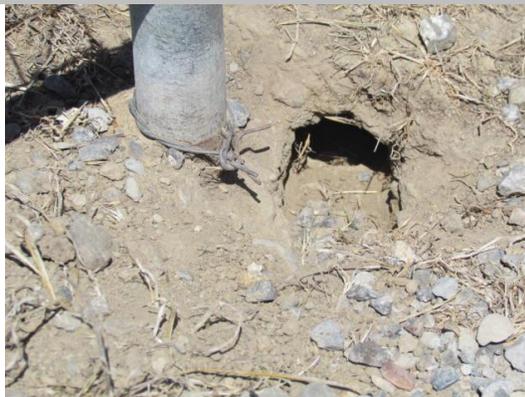
Photo 2 of 2 : SP\_2016\_NA0010\_118\_10\_20160523\_00234.jpg

LM Start	<b>3.16</b>	Rating **	M	Issue No.	<b>10 (cont)</b>
LM End	<b>3.16</b>	Issue Type +	Ma	Location *	LS
Category	Earthen Levee		GPS Latitude/Longitude		
			Start	End	
Item	Animal Control		37.321053 °	37.321053 °	
			-120.928785 °	-120.928785 °	
DWR ID	DWR_NA0010_01_s_2012_10				
Comment Code					
A3 : No rodents visible, but rodent burrows visible; need to backfill and compact or grout burrows.					
Inspector Comment					
Several rodent holes noted in this section. Rodent hole noted on waterward shoulder next fence pole.

Looking at rodent hole next to fence pole on landward shoulder.

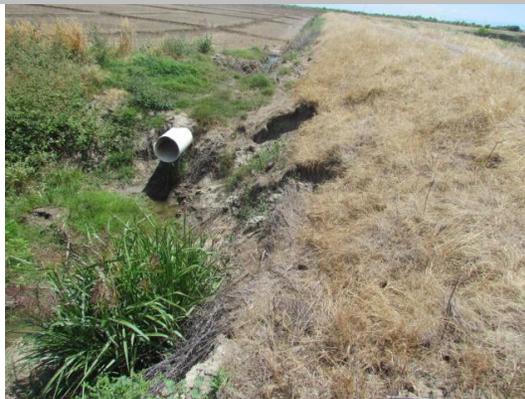
Photo 1 of 3 : SP\_2016\_NA0010\_118\_1179\_20160512\_00025.jpg

LM Start	<b>3.47</b>	Rating **	U	Issue No.	<b>1179</b>
LM End	<b>3.47</b>	Issue Type +	Ma	Location *	LS
Category	Earthen Levee		GPS Latitude/Longitude		
			Start	End	
Item	Erosion / Bank Caving		37.317057 °	37.317057 °	
			-120.926443 °	-120.926443 °	
DWR ID	DWR_NA0010_01_s_2015_1179				
Comment Code					
E1 : Note and monitor erosion site.					
Inspector Comment					
Several erosions greater than three inches on landward slope.

Looking south at erosion on landward slope and toe.

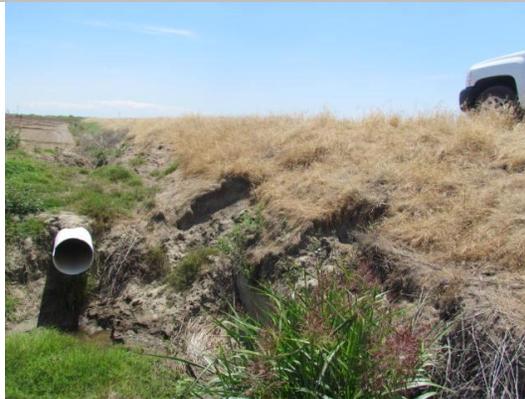
Photo 2 of 3 : SP\_2016\_NA0010\_118\_1179\_20160512\_00026.jpg

Looking southwest at erosion on landward slope and toe.

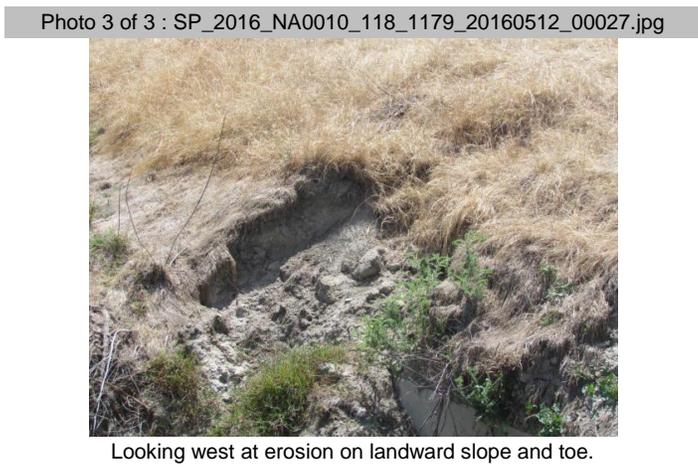
LM Start	<b>3.47</b>	Rating **	U	Issue No.	<b>1179 (cont)</b>
LM End	<b>3.47</b>	Issue Type +	Ma	Location *	LS
Category	Earthen Levee			GPS Latitude/Longitude	
				Start	End
Item	Erosion / Bank Caving			37.317057 °	37.317057 °
				-120.926443 °	-120.926443 °
DWR ID	DWR_NA0010_01_s_2015_1179				
Comment Code					
E1 : Note and monitor erosion site.					
Inspector Comment					
Several erosions greater than three inches on landward slope.

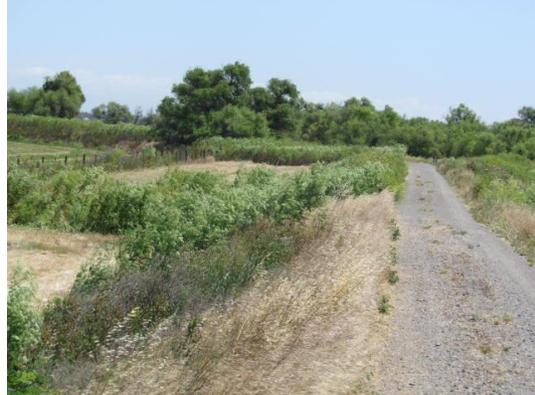
Photo 1 of 1 : SP\_2016\_NA0010\_118\_93\_20160523\_00235.jpg

LM Start	<b>5.87</b>	Rating **	U	Issue No.	<b>93</b>
LM End	<b>6.86</b>	Issue Type +	Ma	Location *	WS
Category	Earthen Levee		GPS Latitude/Longitude		
			Start	End	
Item	Vegetation		37.302156 °	37.302156 °	
			-120.888031 °	-120.888031 °	
DWR ID	DWR_NA0010_01_f_2015_93				
Comment Code					
V2 : Remove the wild growth other than native grasses from the levee slopes.					
Inspector Comment

Looking south at dense veg on waterward slope.

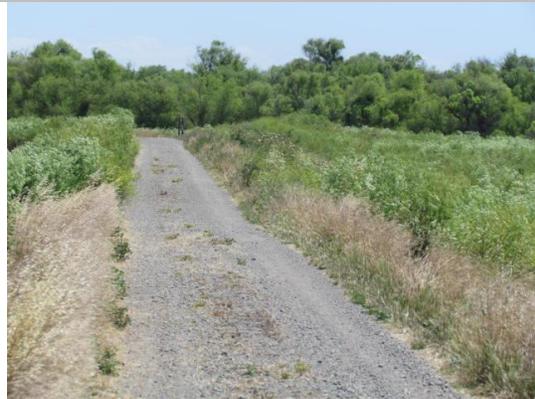
Photo 1 of 1 : SP\_2016\_NA0010\_118\_92\_20160523\_00236.jpg

LM Start	<b>5.87</b>	Rating **	U	Issue No.	<b>92</b>
LM End	<b>6.86</b>	Issue Type +	Ma	Location *	LS
Category	Earthen Levee		GPS Latitude/Longitude		
			Start	End	
Item	Vegetation		37.303555 °	37.302156 °	
			-120.904541 °	-120.888030 °	
DWR ID	DWR_NA0010_01_f_2015_92				
Comment Code					
V2 : Remove the wild growth other than native grasses from the levee slopes.					
Inspector Comment

Looking south at dense veg on landward slope.

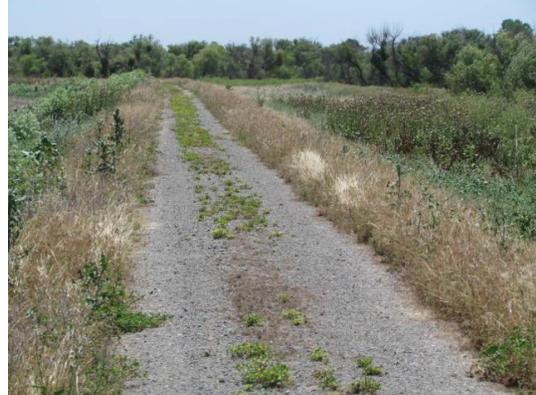
Photo 1 of 1 : SP\_2016\_NA0010\_118\_94\_20160523\_00239.jpg

LM Start	<b>9.03</b>	Rating **	U	Issue No.	<b>94</b>
LM End	<b>9.72</b>	Issue Type +	Ma	Location *	WS
Category	Earthen Levee		GPS Latitude/Longitude		
			Start	End	
Item	Vegetation		37.297380 °	37.293801 °	
			-120.850388 °	-120.839759 °	
DWR ID	DWR_NA0010_01_f_2015_94				
Comment Code					
V2 : Remove the wild growth other than native grasses from the levee slopes.					
Inspector Comment

Looking southwest at dense veg on waterward slope.

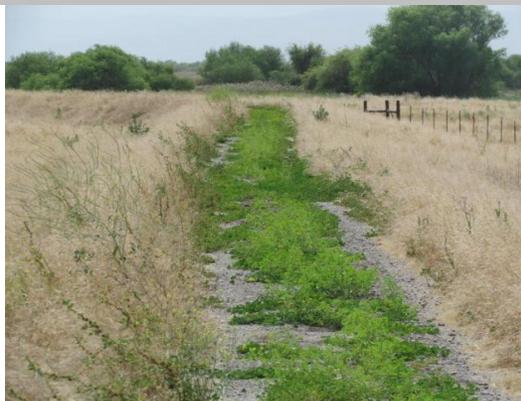
Photo 1 of 1 : SP\_2016\_NA0010\_119\_24\_20160523\_00065.jpg

LM Start	<b>0.00</b>	Rating **	M	Issue No.	<b>24</b>
LM End	<b>2.30</b>	Issue Type +	Ma	Location *	LS
Category	Earthen Levee		GPS Latitude/Longitude		
			Start	End	
Item	Crown Surface / Depressions / Rutting		37.296313 °	37.291556 °	
			-120.880576 °	-120.851252 °	
DWR ID	DWR_NA0010_02A_s_2016_24				
Comment Code					
C1 : Add appropriate material and re-grade the levee to bring the crown above the design elevation.					
Inspector Comment					
Control annual weeds and regrade levee crown.

Looking northeast at veg on levee crown.

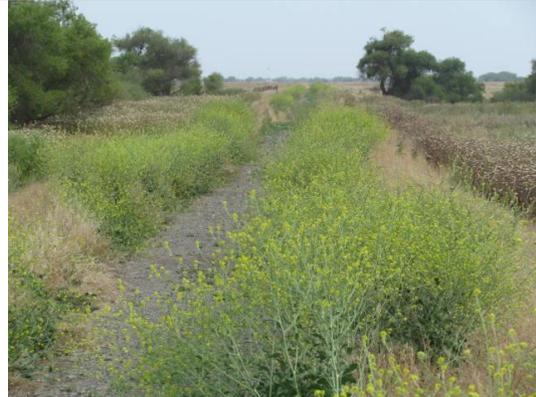
Photo 1 of 1 : SP\_2016\_NA0010\_119\_27\_20160523\_00070.jpg

LM Start	<b>0.00</b>	Rating **	U	Issue No.	<b>27</b>
LM End	<b>2.30</b>	Issue Type +	Ma	Location *	LS
Category	Earthen Levee		GPS Latitude/Longitude		
			Start	End	
Item	Vegetation		37.296305 °	37.291556 °	
			-120.880567 °	-120.851252 °	
DWR ID	DWR_NA0010_02A_f_2015_27				
Comment Code					
V2 : Remove the wild growth other than native grasses from the levee slopes.					
Inspector Comment

Looking at dense veg on landward slope.

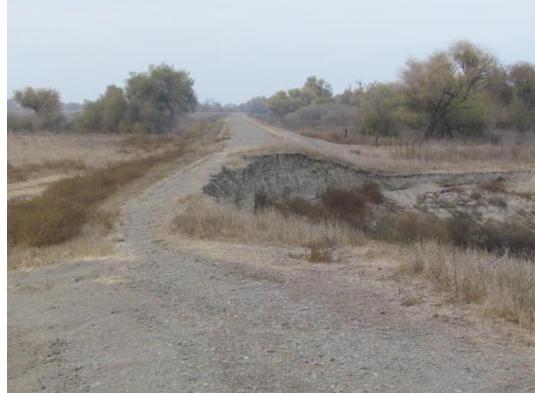
Photo 2 of 3 : SP\_2016\_NA0010\_119\_5\_20160512\_00004.jpg

LM Start	<b>0.75</b>	Rating **	U	Issue No.	<b>5 (cont)</b>
LM End	<b>0.75</b>	Issue Type +	Ma	Location *	WS
Category	Earthen Levee			GPS Latitude/Longitude	
				Start	End
Item	Erosion / Bank Caving			37.286877 °	37.286877 °
				-120.874222 °	-120.874222 °
DWR ID	DWR_NA0010_02A_s_2012_5				
Comment Code					
E2 : Schedule repair of erosion site prior to the next inspection.					
Inspector Comment					
A field investigation report in on file. For more information and pictures see field investigation report #4301.

Looking north at large erosion on waterward slope. (Fall 2013)

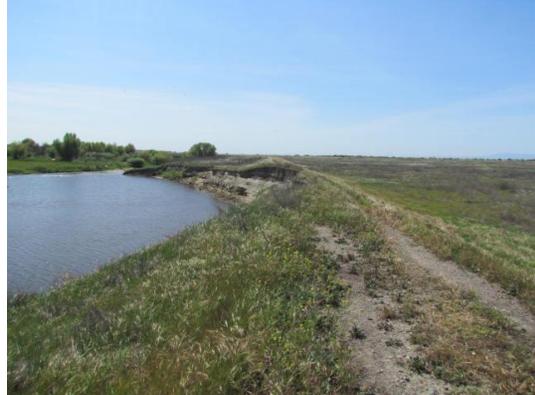
Photo 3 of 3 : SP\_2016\_NA0010\_119\_5\_20160512\_00005.jpg

Looking south at large erosion on waterside slope. (Spring 2012)

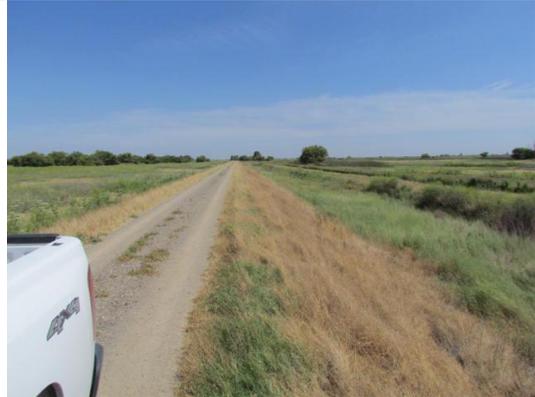
Photo 1 of 1 : SP\_2016\_NA0010\_120\_17\_20160523\_00006.jpg

LM Start	<b>7.87</b>	Rating **	M	Issue No.	<b>17</b>
LM End	<b>13.75</b>	Issue Type +	Ma	Location *	LS
Category	Earthen Levee		GPS Latitude/Longitude		
			Start	End	
Item	Vegetation		37.231291 °	37.172165 °	
			-120.811871 °	-120.761208 °	
DWR ID	DWR_NA0010_02B_s_2016_17				
Comment Code					
V1 : Control annual grass and weeds on the levee slopes and easements.					
Inspector Comment

Looking at typical view of landward slope.

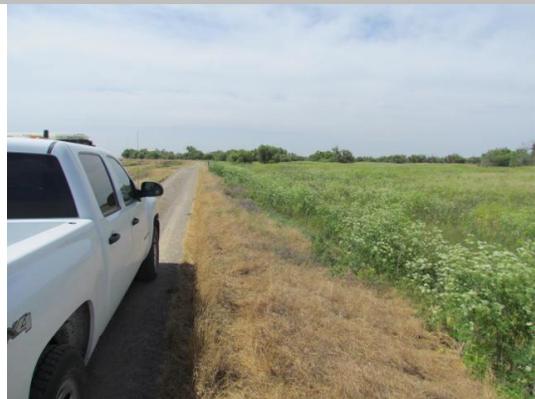
Photo 1 of 1 : SP\_2016\_NA0010\_120\_18\_20160523\_00007.jpg

LM Start	<b>7.87</b>	Rating **	M	Issue No.	<b>18</b>
LM End	<b>13.75</b>	Issue Type +	Ma	Location *	WS
Category	Earthen Levee		GPS Latitude/Longitude		
			Start	End	
Item	Vegetation		37.231291 °	37.172166 °	
			-120.811871 °	-120.761209 °	
DWR ID	DWR_NA0010_02B_s_2016_18				
Comment Code					
V1 : Control annual grass and weeds on the levee slopes and easements.					
Inspector Comment

Looking north at typical view of waterward slope.

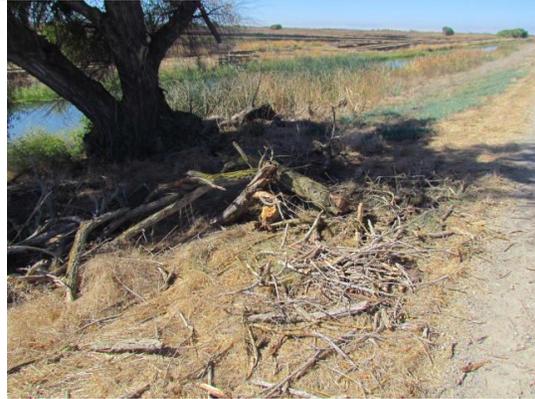
Photo 1 of 1 : SP\_2016\_NA0010\_120\_14\_20160512\_00005.jpg

LM Start	<b>10.94</b>	Rating **	M	Issue No.	<b>14</b>
LM End	<b>10.94</b>	Issue Type +	Ma	Location *	LS
Category	Earthen Levee		GPS Latitude/Longitude		
			Start	End	
Item	Encroachments		37.205711 °	37.205711 °	
			-120.774741 °	-120.774741 °	
DWR ID	DWR_NA0010_02B_f_2015_14				
Comment Code					
PR : Prunings					
Inspector Comment					
Prunings on landward slope.

Looking at prunings on landward slope.

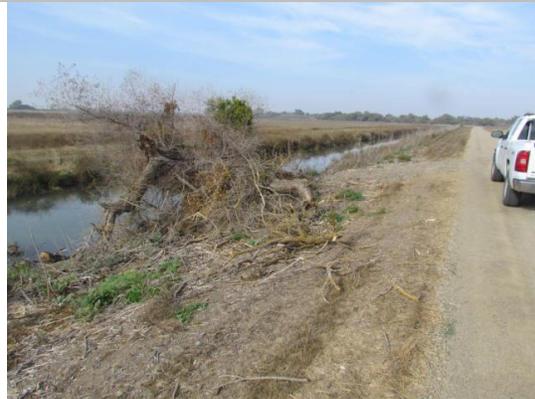
Photo 1 of 2 : SP\_2016\_NA0010\_120\_1\_20160512\_00001.jpg

LM Start	<b>12.21</b>	Rating **	M	Issue No.	<b>1</b>
LM End	<b>12.21</b>	Issue Type +	Ma	Location *	LS
Category	Earthen Levee		GPS Latitude/Longitude		
			Start	End	
Item	Encroachments		37.191528 °	37.191528 °	
			-120.764541 °	-120.764541 °	
DWR ID	DWR_NA0010_02B_f_2014_1				
Comment Code					
TR : Tree or limb					
Inspector Comment					
Fallen tree limbs on landward slope.

Looking southwest at tree limb on waterward slope.

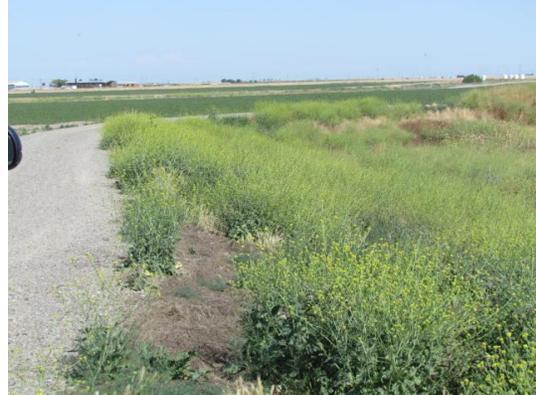
Photo 1 of 1 : SP\_2016\_NA0010\_121\_7\_20160523\_00012.jpg

LM Start	<b>0.00</b>	Rating **	M	Issue No.	<b>7</b>
LM End	<b>2.09</b>	Issue Type +	Ma	Location *	WS
Category	Earthen Levee		GPS Latitude/Longitude		
			Start	End	
Item	Vegetation		37.111700 °	37.088992 °	
			-120.587580 °	-120.566894 °	
DWR ID	DWR_NA0010_03_s_2016_7				
Comment Code					
V1 : Control annual grass and weeds on the levee slopes and easements.					
Inspector Comment

Looking east at veg on waterward slope.

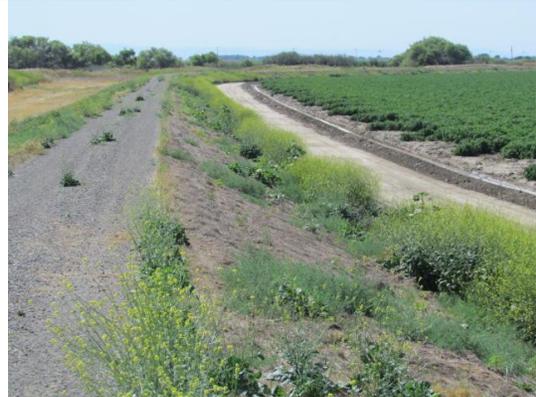
Photo 1 of 1 : SP\_2016\_NA0010\_121\_5\_20160523\_00013.jpg

LM Start	<b>0.00</b>	Rating **	M	Issue No.	<b>5</b>
LM End	<b>2.09</b>	Issue Type +	Ma	Location *	LS
Category	Earthen Levee		GPS Latitude/Longitude		
			Start	End	
Item	Vegetation		37.111699 °	37.088993 °	
			-120.587580 °	-120.566895 °	
DWR ID	DWR_NA0010_03_s_2016_5				
Comment Code					
V1 : Control annual grass and weeds on the levee slopes and easements.					
Inspector Comment

Looking west at landward slope.

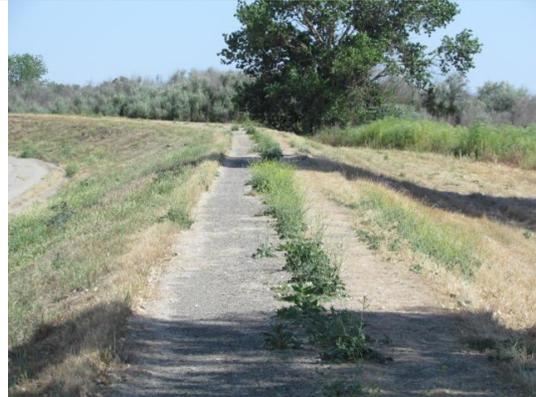
Photo 1 of 1 : SP\_2016\_NA0010\_121\_4\_20160523\_00014.jpg

LM Start	<b>0.48</b>	Rating **	M	Issue No.	<b>4</b>
LM End	<b>2.03</b>	Issue Type +	Ma	Location *	CR
Category	Earthen Levee		GPS Latitude/Longitude		
			Start	End	
Item	Vegetation		37.105485°	37.089425°	
			-120.585086°	-120.567777°	
DWR ID	DWR_NA0010_03_s_2016_4				
Comment Code					
V1 : Control annual grass and weeds on the levee slopes and easements.					
Inspector Comment					
Control annual weeds on levee crown.

Looking west at veg on levee crown.

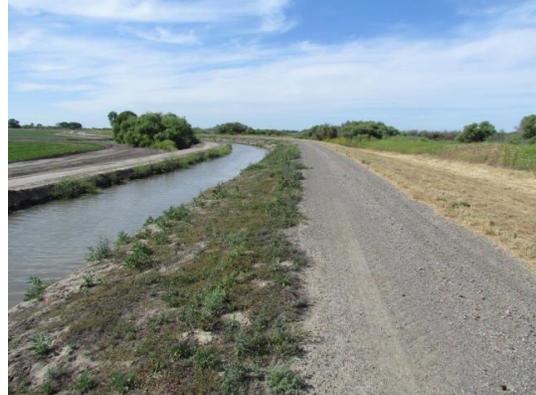
Photo 1 of 1 : SP\_2016\_NA0010\_122\_11\_20160523\_00026.jpg

LM Start	<b>0.00</b>	Rating **	M	Issue No.	<b>11</b>
LM End	<b>1.41</b>	Issue Type +	Ma	Location *	LS
Category	Earthen Levee		GPS Latitude/Longitude		
			Start	End	
Item	Vegetation		37.112579 °	37.097555 °	
			-120.589106 °	-120.578130 °	
DWR ID	DWR_NA0010_04_s_2016_11				
Comment Code					
V1 : Control annual grass and weeds on the levee slopes and easements.					
Inspector Comment

Looking southeast at landward slope.

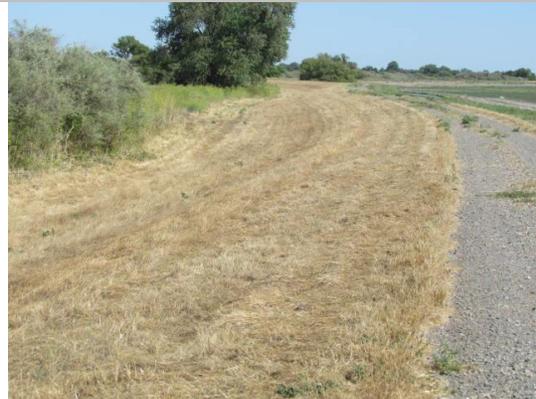
Photo 1 of 1 : SP\_2016\_NA0010\_122\_12\_20160523\_00025.jpg

LM Start	<b>0.00</b>	Rating **	A	Issue No.	<b>12</b>
LM End	<b>1.41</b>	Issue Type +	Ma	Location *	WS
Category	Earthen Levee		GPS Latitude/Longitude		
			Start	End	
Item	Vegetation		37.112579 °	37.097555 °	
			-120.589106 °	-120.578130 °	
DWR ID	DWR_NA0010_04_s_2016_12				
Comment Code					
V1 : Control annual grass and weeds on the levee slopes and easements.					
Inspector Comment

Looking north at waterward slope.

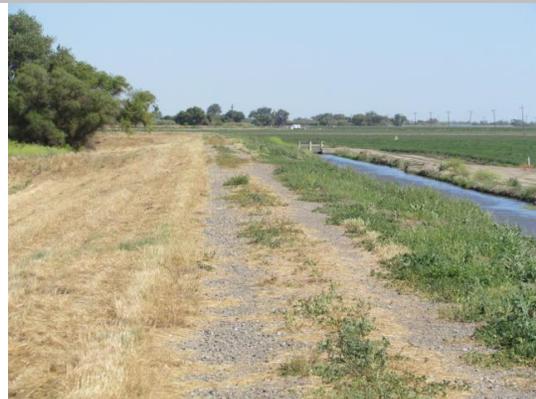
Photo 1 of 1 : SP\_2016\_NA0010\_122\_4\_20160523\_00027.jpg

LM Start	<b>0.54</b>	Rating **	M	Issue No.	<b>4</b>
LM End	<b>1.41</b>	Issue Type +	Ma	Location *	CR
Category	Earthen Levee		GPS Latitude/Longitude		
			Start	End	
Item	Vegetation		37.106025 °	37.097556 °	
			-120.588746 °	-120.578129 °	
DWR ID	DWR_NA0010_04_s_2016_4				
Comment Code					
V1 : Control annual grass and weeds on the levee slopes and easements.					
Inspector Comment					
Control annual weeds on levee crown.

Looking north at levee crown.

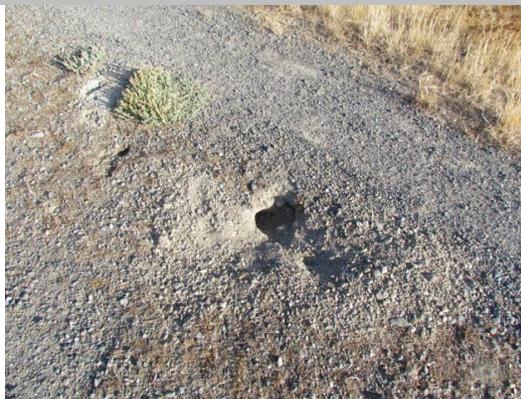
Photo 1 of 1 : SP\_2016\_NA0010\_123\_80\_20160512\_00008.jpg

LM Start	<b>1.66</b>	Rating **	M	Issue No.	<b>80</b>
LM End	<b>1.75</b>	Issue Type +	Ma	Location *	LS
Category	Earthen Levee		GPS Latitude/Longitude		
			Start	End	
Item	Animal Control		37.263448 °	37.262225 °	
			-120.802715 °	-120.802296 °	
DWR ID	DWR_NA0010_05_f_2015_80				
Comment Code					
A3 : No rodents visible, but rodent burrows visible; need to backfill and compact or grout burrows.					
Inspector Comment					
Several rodent holes on levee crown within this section.

Looking at typical view of rodent holes within this section on landward slope.

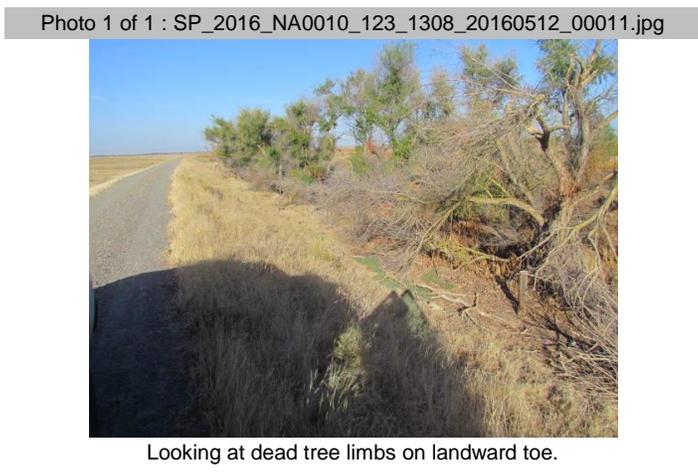
LM Start	<b>2.82</b>	Rating **	M	Issue No.	<b>1308</b>
LM End	<b>2.82</b>	Issue Type +	Ma	Location *	LS
Category	Earthen Levee			GPS Latitude/Longitude	
				Start	End
Item	Encroachments			37.256783 °	37.256783 °
				-120.785438 °	-120.785438 °
DWR ID	DWR_NA0010_05_s_2015_1308				
Comment Code					
TR : Tree or limb					
Inspector Comment					
Dead tree limbs at landward toe.

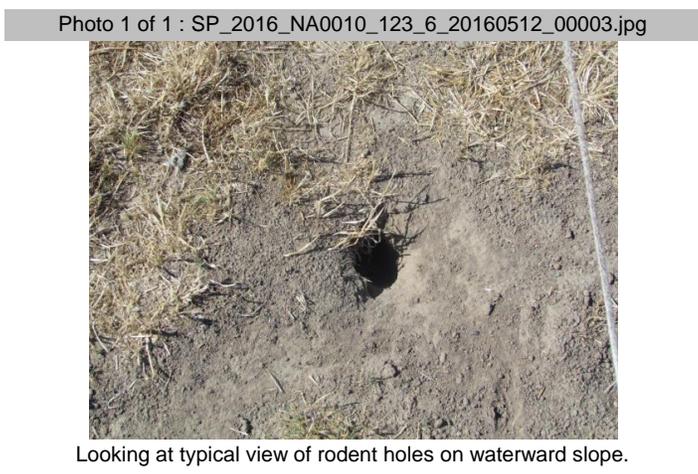
LM Start	<b>3.20</b>	Rating **	M	Issue No.	<b>6</b>
LM End	<b>3.20</b>	Issue Type +	Ma	Location *	WS
Category	Earthen Levee			GPS Latitude/Longitude	
				Start	End
Item	Animal Control			37.256635 °	37.256635 °
				-120.778935 °	-120.778935 °
DWR ID	DWR_NA0010_05_s_2014_6				
Comment Code					
A1 : Exterminate rodents and backfill and compact or grout burrows.					
Inspector Comment					
No rodent visible but several rodent holes visible.

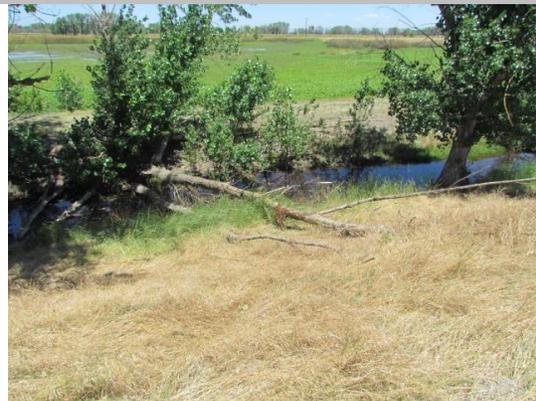
Photo 1 of 1 : SP\_2016\_NA0010\_123\_2\_20160523\_00207.jpg

LM Start	<b>13.01</b>	Rating **	M	Issue No.	<b>2</b>
LM End	<b>13.01</b>	Issue Type +	Ma	Location *	LS
Category	Earthen Levee		GPS Latitude/Longitude		
			Start	End	
Item	Encroachments		37.175576 °	37.175576 °	
			-120.638755 °	-120.638755 °	
DWR ID	DWR_NA0010_05_s_2016_2				
Comment Code					
TR : Tree or limb					
Inspector Comment					
Downed tree on landward toe.

Looking west at down tree at landward toe.

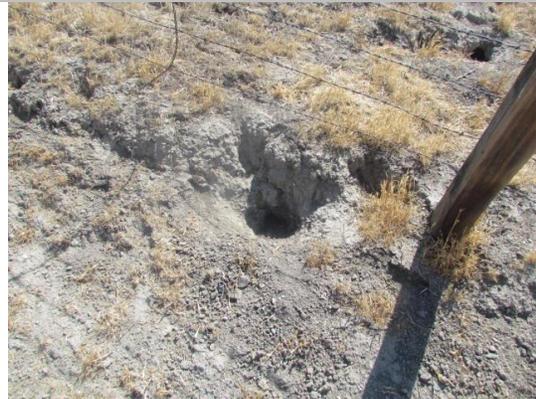
Photo 1 of 2 : SP\_2016\_NA0010\_124\_10\_20160512\_00012.jpg

LM Start	<b>4.66</b>	Rating **	M	Issue No.	<b>10</b>
LM End	<b>4.66</b>	Issue Type +	Ma	Location *	LS
Category	Earthen Levee		GPS Latitude/Longitude		
			Start	End	
Item	Animal Control		37.243540°	37.243540°	
			-120.760782°	-120.760782°	
DWR ID	DWR_NA0010_06_s_2012_10				
Comment Code					
A3 : No rodents visible, but rodent burrows visible; need to backfill and compact or grout burrows.					
Inspector Comment					
Rodent holes next to fence post on landward slope.

Looking at rodent hole along fence line on landward slope.

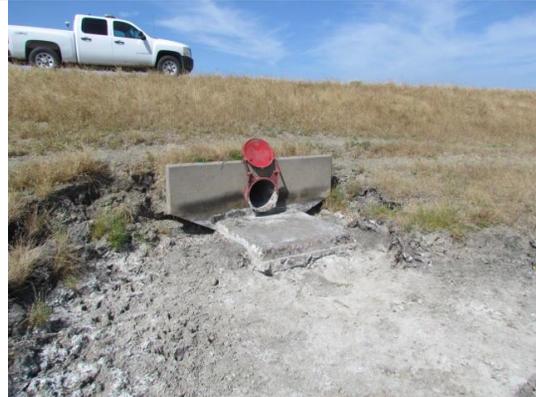
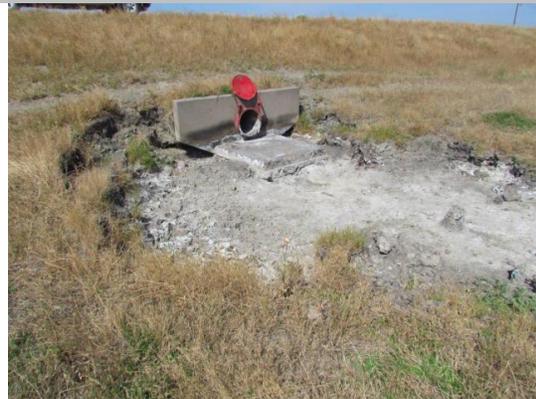
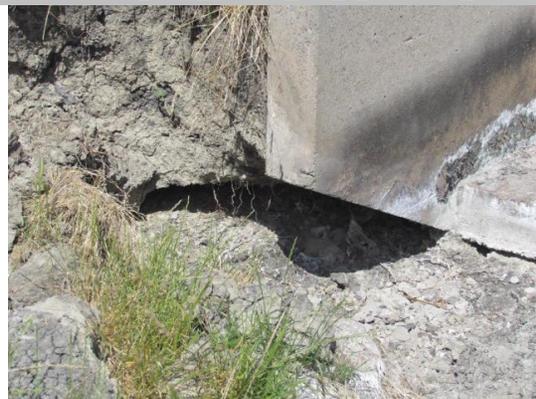
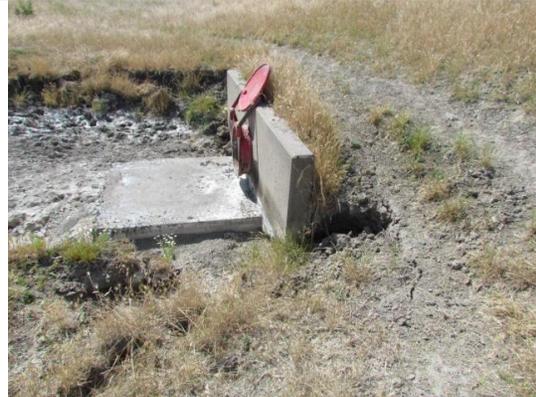
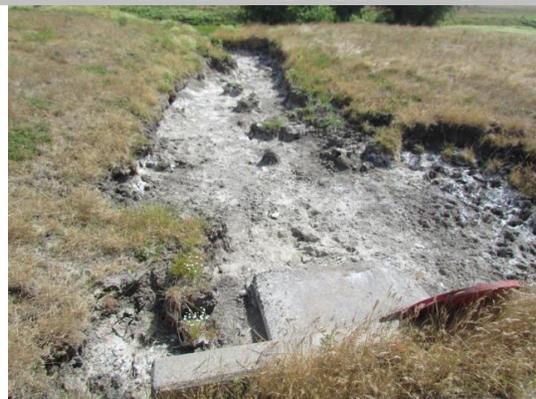
LM Start	<b>5.98</b>	Rating **	U	Issue No.	<b>1</b>
LM End	<b>5.98</b>	Issue Type +	Ma	Location *	WS
Category	Interior Drainage & Piping Systems		GPS Latitude/Longitude		
			Start	End	
Item	Erosion Areas		37.236386°	37.236386°	
			-120.739706°	-120.739706°	
DWR ID	DWR_NA0010_06_s_2016_1				
Comment Code					
Inspector Comment					
Erosion is undermining the headwall on both sides of the drainage structure.

LM Start	<b>5.98</b>	Rating **	U	Issue No.	<b>1 (cont)</b>
LM End	<b>5.98</b>	Issue Type +	Ma	Location *	WS
Category	Interior Drainage & Piping Systems			GPS Latitude/Longitude	
				Start	End
Item	Erosion Areas			37.236386 °	37.236386 °
				-120.739706 °	-120.739706 °
DWR ID	DWR_NA0010_06_s_2016_1				
Comment Code					
Inspector Comment					
Erosion is undermining the headwall on both sides of the drainage structure.

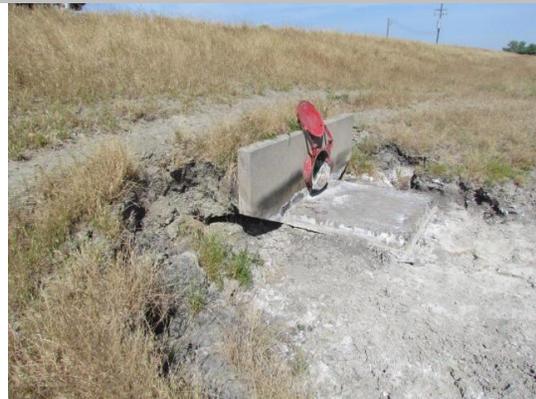
Photo 5 of 6 : SP\_2016\_NA0010\_124\_1\_20160523\_00169.jpg

Looking west at erosion on waterside around structure.

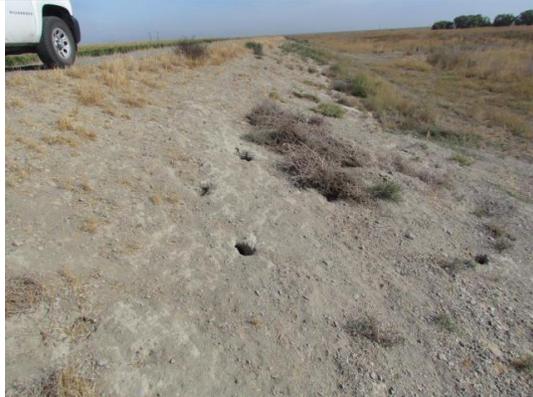
Photo 2 of 5 : SP\_2016\_NA0010\_124\_1211\_20160512\_00037.jpg

LM Start	<b>19.14</b>	Rating **	U	Issue No.	<b>1211 (cont)</b>
LM End	<b>19.14</b>	Issue Type +	Ma	Location *	WS
Category	Earthen Levee			GPS Latitude/Longitude	
				Start	End
Item	Animal Control			37.114793 °	37.114793 °
				-120.587582 °	-120.587582 °
DWR ID	DWR_NA0010_06_s_2015_1211				
Comment Code					
A1 : Exterminate rodents and backfill and compact or grout burrows.					
Inspector Comment					
Several large rodent holes with more than 2 cubic feet of material was noted on waterward slope

Looking at several rodent holes on waterward slope. (Fall 2015)

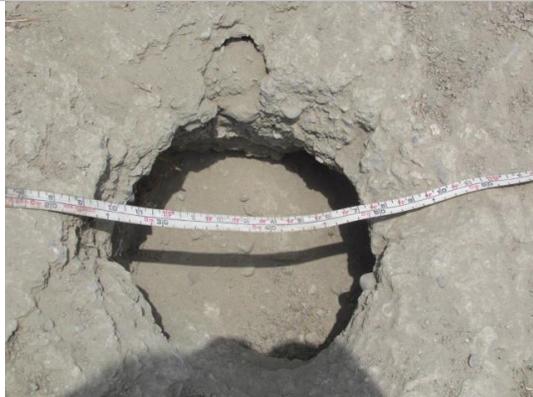
Photo 3 of 5 : SP\_2016\_NA0010\_124\_1211\_20160512\_00038.jpg

Looking at close-up view of large rodent hole on waterward slope. (Spring 2015)

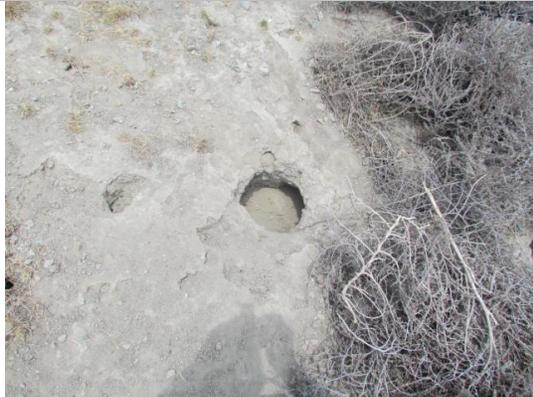
Photo 4 of 5 : SP\_2016\_NA0010\_124\_1211\_20160512\_00039.jpg

Looking at large rodent hole on waterward slope. Spring 2015

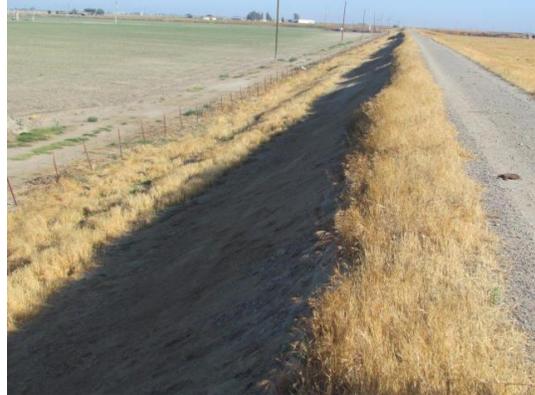
Photo 2 of 3 : SP\_2016\_NA0010\_124\_5\_20160512\_00008.jpg

LM Start	<b>24.58</b>	Rating **	M	Issue No.	<b>5 (cont)</b>
LM End	<b>24.93</b>	Issue Type +	Ma	Location *	LS
Category	Earthen Levee			GPS Latitude/Longitude	
				Start	End
Item	Slope Stability			37.071198 °	°
				-120.519220 °	°
DWR ID	DWR_NA0010_06_s_2012_5				
Comment Code					
S2 : Repair the levee slope damaged by foot traffic and prevent access where possible.					
Inspector Comment					
Landside erosion caused by livestock.

Looking north at livestock erosion on landward slope. (Spring 2014)

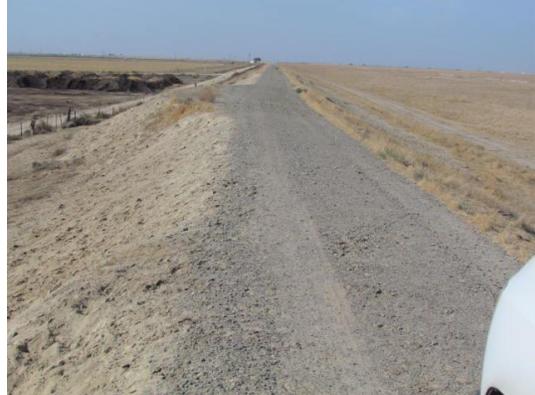
Photo 1 of 4 : SP\_2016\_NA0010\_124\_3\_20160512\_00003.jpg

Looking north at livestock erosion on landward slope. Fall 2015

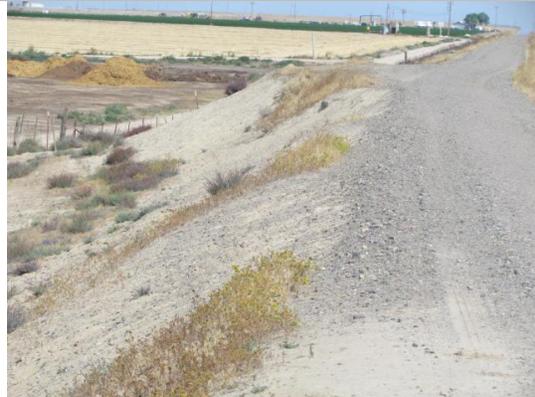
Photo 2 of 4 : SP\_2016\_NA0010\_124\_3\_20160512\_00004.jpg

Looking north at livestock erosion on landward shoulder and slope.(Spring 2015)

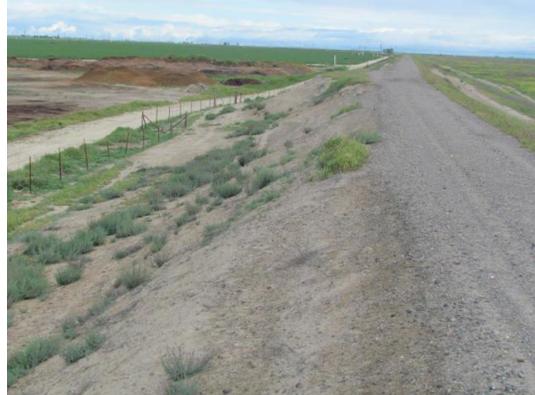
Photo 3 of 4 : SP\_2016\_NA0010\_124\_3\_20160512\_00005.jpg

Looking north at livestock erosion on landside shoulder and slope. (Fall 2014)

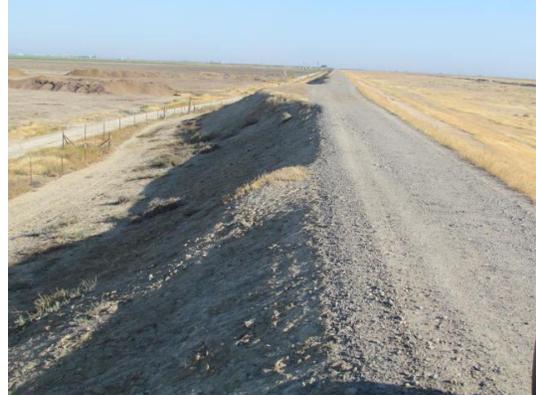
Photo 4 of 4 : SP\_2016\_NA0010\_124\_3\_20160512\_00006.jpg

LM Start	<b>27.64</b>	Rating **	M	Issue No.	<b>3 (cont)</b>
LM End	<b>27.97</b>	Issue Type +	Ma	Location *	LS
Category	Earthen Levee		GPS Latitude/Longitude		
			Start	End	
Item	Slope Stability		37.036955 °	37.032887 °	
			-120.484395 °	-120.481225 °	
DWR ID	DWR_NA0010_06_s_2012_3				
Comment Code					
S2 : Repair the levee slope damaged by foot traffic and prevent access where possible.					
Inspector Comment					
Landside erosion caused by livestock. Erosion greater than 3" in depth on landward slope. Levee crown has narrowed within this reach.

Looking north at livestock erosion on landward slope. (Spring 2013)

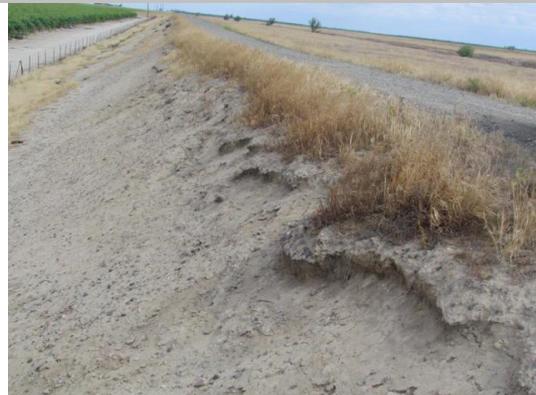
Photo 1 of 2 : SP\_2016\_NA0010\_124\_1207\_20160512\_00031.jpg

LM Start	<b>30.81</b>	Rating **	U	Issue No.	<b>1207</b>
LM End	<b>31.06</b>	Issue Type +	Ma	Location *	LS
Category	Earthen Levee		GPS Latitude/Longitude		
			Start	End	
Item	Erosion / Bank Caving		37.021615 °	37.018428 °	
			-120.437587 °	-120.435378 °	
DWR ID	DWR_NA0010_06_s_2015_1207				
Comment Code					
E1 : Note and monitor erosion site.					
Inspector Comment					
Landward erosion greater than 1" in depth and greater than 3" in length. Erosion caused by livestock traffic.

Looking northeast at livestock erosion on landward slope.

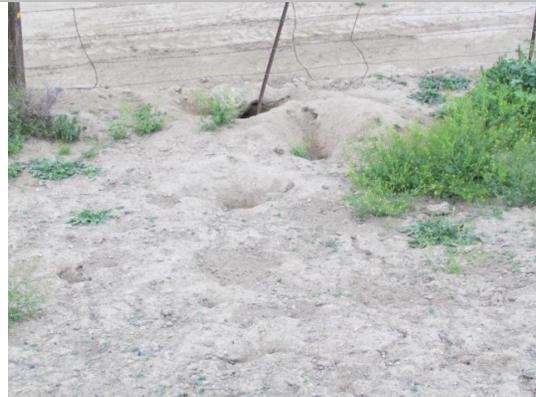
Photo 1 of 2 : SP\_2016\_NA0010\_124\_2\_20160512\_00001.jpg

LM Start	<b>31.10</b>	Rating **	U	Issue No.	<b>2</b>
LM End	<b>31.10</b>	Issue Type +	Ma	Location *	LS
Category	Earthen Levee			GPS Latitude/Longitude	
				Start	End
Item	Animal Control			37.017955 °	37.017955 °
				-120.435017 °	-120.435017 °
DWR ID	DWR_NA0010_06_s_2012_2				
Comment Code					
A1 : Exterminate rodents and backfill and compact or grout burrows.					
Inspector Comment

Looking west at rodent holes on landside slope and toe near fence line.

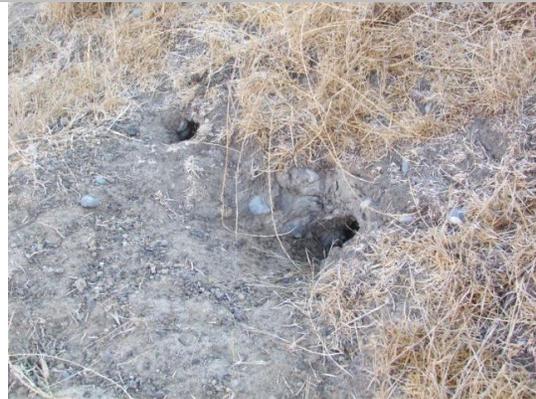
Photo 1 of 2 : SP\_2016\_NA0010\_125\_1\_20160512\_00001.jpg

LM Start	<b>1.22</b>	Rating **	M	Issue No.	<b>1</b>
LM End	<b>1.22</b>	Issue Type +	Ma	Location *	LS
Category	Earthen Levee			GPS Latitude/Longitude	
				Start	End
Item	Animal Control			37.264387 °	37.264387 °
				-120.755805 °	-120.755805 °
DWR ID	DWR_NA0010_07_f_2012_1				
Comment Code					
A1 : Exterminate rodents and backfill and compact or grout burrows.					
Inspector Comment

Looking north at several rodent holes on landward slope.

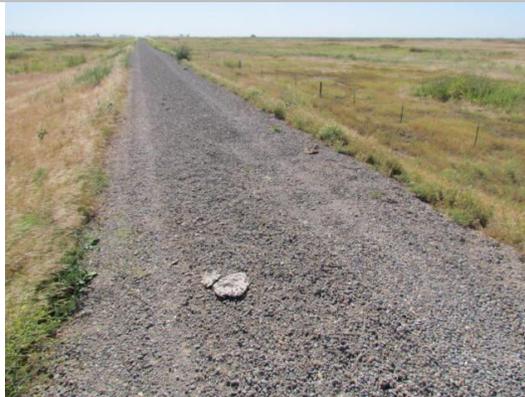
Photo 1 of 1 : SP\_2016\_NA0010\_126\_5\_20160523\_00025.jpg

LM Start	<b>1.16</b>	Rating **	M	Issue No.	<b>5</b>
LM End	<b>1.16</b>	Issue Type +	Ma	Location *	CR
Category	Earthen Levee			GPS Latitude/Longitude	
				Start	End
Item	Crown Surface / Depressions / Rutting			37.263243 °	37.263243 °
				-120.756372 °	-120.756372 °
DWR ID	DWR_NA0010_08_s_2016_5				
Comment Code					
C2 : Repair depressions or ruts in the crown or slope.					
Inspector Comment					
Depression noted on levee crown.

Looking west at depression on toward landward shoulder.

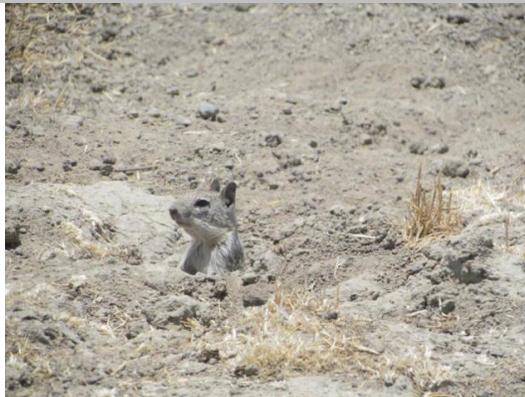
Photo 1 of 1 : SP\_2016\_NA0010\_126\_8\_20160512\_00003.jpg

LM Start	<b>1.38</b>	Rating **	M	Issue No.	<b>8</b>
LM End	<b>1.38</b>	Issue Type +	Ma	Location *	LS
Category	Earthen Levee			GPS Latitude/Longitude	
				Start	End
Item	Animal Control			37.263175 °	37.263175 °
				-120.752307 °	-120.752307 °
DWR ID	DWR_NA0010_08_s_2013_8				
Comment Code					
A1 : Exterminate rodents and backfill and compact or grout burrows.					
Inspector Comment

Looking west at rodent holes on landward slope.

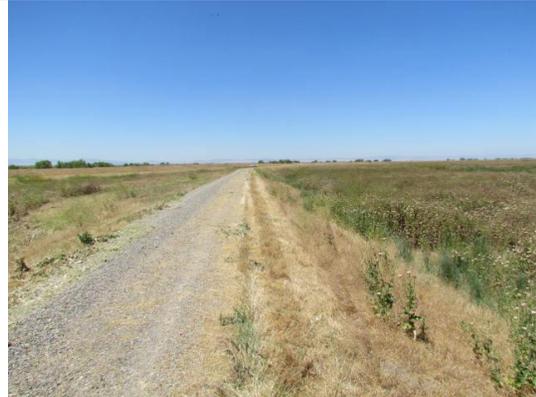
Photo 1 of 1 : SP\_2016\_NA0010\_127\_3\_20160523\_00008.jpg

LM Start	<b>0.00</b>	Rating **	M	Issue No.	<b>3</b>
LM End	<b>0.87</b>	Issue Type +	Ma	Location *	LS
Category	Earthen Levee		GPS Latitude/Longitude		
			Start	End	
Item	Vegetation		37.220261 °	37.220065 °	
			-120.713028 °	-120.698350 °	
DWR ID	DWR_NA0010_09_s_2016_3				
Comment Code					
V1 : Control annual grass and weeds on the levee slopes and easements.					
Inspector Comment

Looking west at typical view of waterward slope.

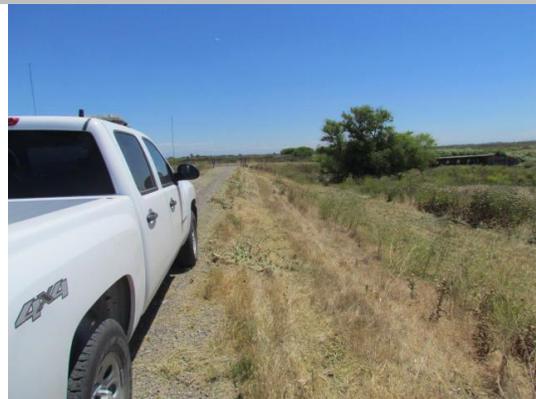
Photo 1 of 1 : SP\_2016\_NA0010\_127\_4\_20160523\_00007.jpg

LM Start	<b>0.00</b>	Rating **	M	Issue No.	<b>4</b>
LM End	<b>0.87</b>	Issue Type +	Ma	Location *	WS
Category	Earthen Levee		GPS Latitude/Longitude		
			Start	End	
Item	Vegetation		37.220262 °	37.220065 °	
			-120.713028 °	-120.698350 °	
DWR ID	DWR_NA0010_09_s_2016_4				
Comment Code					
V1 : Control annual grass and weeds on the levee slopes and easements.					
Inspector Comment

Looking east at typical view of waterward slope.

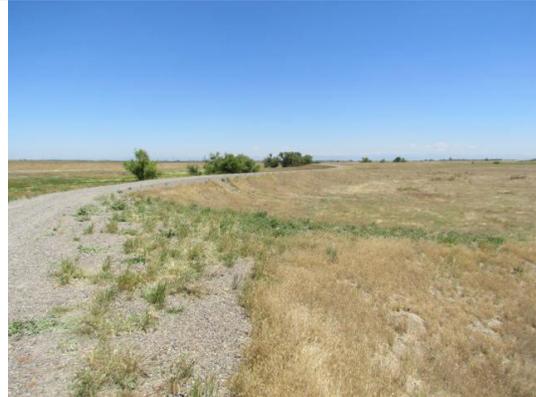
Photo 1 of 1 : SP\_2016\_NA0010\_128\_3\_20160523\_00005.jpg

LM Start	<b>0.00</b>	Rating **	M	Issue No.	<b>3</b>
LM End	<b>0.79</b>	Issue Type +	Ma	Location *	LS
Category	Earthen Levee		GPS Latitude/Longitude		
			Start	End	
Item	Vegetation		37.217903 °	37.219366 °	
			-120.711439 °	-120.698019 °	
DWR ID	DWR_NA0010_10_s_2016_3				
Comment Code					
V1 : Control annual grass and weeds on the levee slopes and easements.					
Inspector Comment

Looking at typical of landward slope.

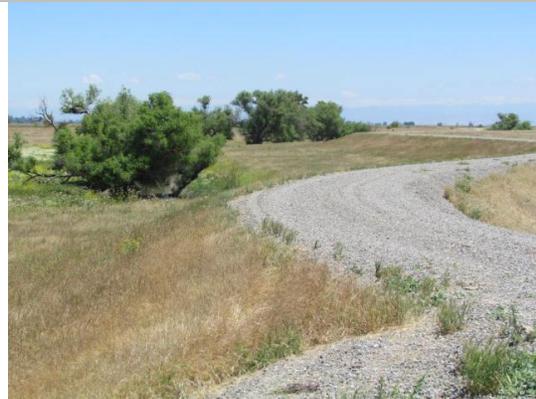
Photo 1 of 1 : SP\_2016\_NA0010\_128\_4\_20160523\_00006.jpg

LM Start	<b>0.00</b>	Rating **	M	Issue No.	<b>4</b>
LM End	<b>0.79</b>	Issue Type +	Ma	Location *	WS
Category	Earthen Levee		GPS Latitude/Longitude		
			Start	End	
Item	Vegetation		37.217903 °	37.219366 °	
			-120.711439 °	-120.698018 °	
DWR ID	DWR_NA0010_10_s_2016_4				
Comment Code					
V1 : Control annual grass and weeds on the levee slopes and easements.					
Inspector Comment

Looking at typical view of waterward slope.

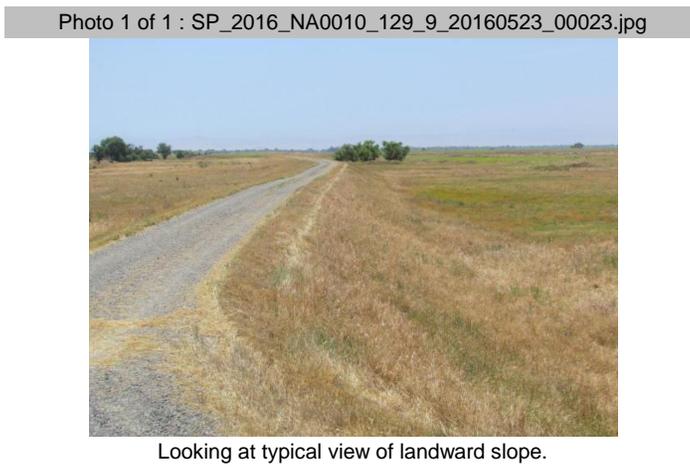
LM Start	<b>0.00</b>	Rating **	A	Issue No.	<b>9</b>
LM End	<b>3.31</b>	Issue Type +	Ma	Location *	LS
Category	Earthen Levee		GPS Latitude/Longitude		
			Start	End	
Item	Vegetation		37.202748 °	37.202310 °	
			-120.755210 °	-120.695281 °	
DWR ID	DWR_NA0010_11_s_2016_9				
Comment Code					
V1 : Control annual grass and weeds on the levee slopes and easements.					
Inspector Comment

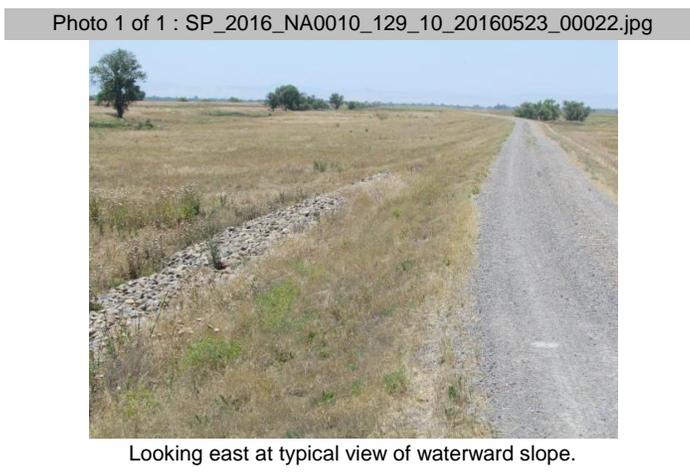
LM Start	<b>0.00</b>	Rating **	A	Issue No.	<b>10</b>
LM End	<b>3.31</b>	Issue Type +	Ma	Location *	WS
Category	Earthen Levee		GPS Latitude/Longitude		
			Start	End	
Item	Vegetation		37.202748 °	37.202310 °	
			-120.755210 °	-120.695281 °	
DWR ID	DWR_NA0010_11_s_2016_10				
Comment Code					
V1 : Control annual grass and weeds on the levee slopes and easements.					
Inspector Comment

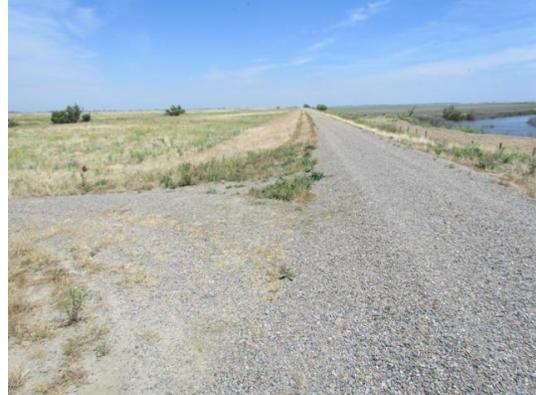
Photo 1 of 1 : SP\_2016\_NA0010\_130\_10\_20160523\_00022.jpg

LM Start	<b>0.00</b>	Rating **	A	Issue No.	<b>10</b>
LM End	<b>3.33</b>	Issue Type +	Ma	Location *	WS
Category	Earthen Levee		GPS Latitude/Longitude		
			Start	End	
Item	Vegetation		37.200939 °	37.200973 °	
			-120.755179 °	-120.694883 °	
DWR ID	DWR_NA0010_12_s_2016_10				
Comment Code					
V1 : Control annual grass and weeds on the levee slopes and easements.					
Inspector Comment

Looking at typical view of waterward slope.

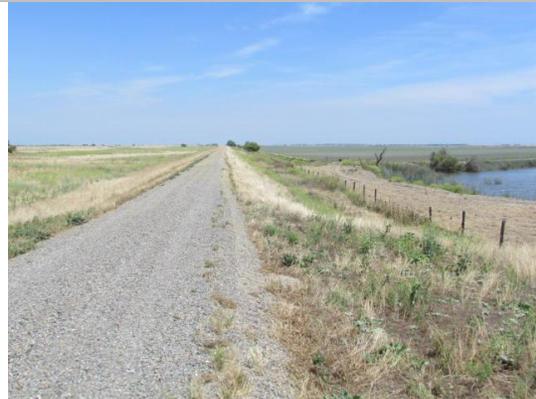
Photo 1 of 1 : SP\_2016\_NA0010\_130\_11\_20160523\_00023.jpg

LM Start	<b>0.00</b>	Rating **	A	Issue No.	<b>11</b>
LM End	<b>3.33</b>	Issue Type +	Ma	Location *	LS
Category	Earthen Levee		GPS Latitude/Longitude		
			Start	End	
Item	Vegetation		37.200939 °	37.200973 °	
			-120.755178 °	-120.694883 °	
DWR ID	DWR_NA0010_12_s_2016_11				
Comment Code					
V1 : Control annual grass and weeds on the levee slopes and easements.					
Inspector Comment

Looking at typical view of landward slope.

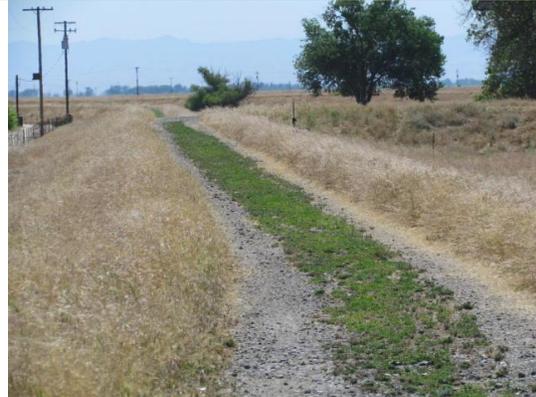
Photo 1 of 1 : SP\_2016\_NA0010\_132\_2\_20160523\_00005.jpg

LM Start	<b>0.00</b>	Rating **	M	Issue No.	<b>2</b>
LM End	<b>1.26</b>	Issue Type +	Ma	Location *	CR
Category	Earthen Levee		GPS Latitude/Longitude		
			Start	End	
Item	Crown Surface / Depressions / Rutting		37.032379 °	37.045404 °	
			-120.441265 °	-120.427749 °	
DWR ID	DWR_NA0010_14_f_2012_2				
Comment Code					
C3 : Add appropriate gravel or road base. Grade and compact.					
Inspector Comment					
Control vegetation on levee crown.

Looking at typical view of levee crown.

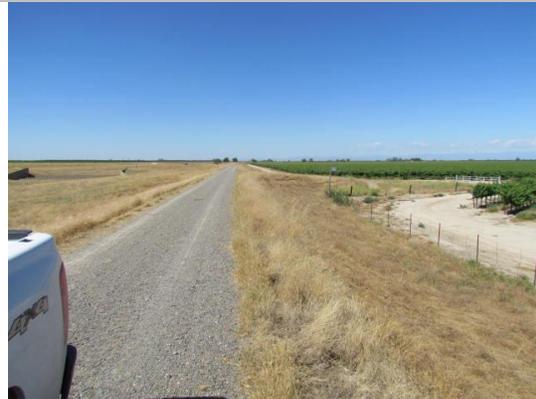
Photo 1 of 1 : SP\_2016\_NA0010\_132\_3\_20160523\_00006.jpg

LM Start	<b>0.00</b>	Rating **	M	Issue No.	<b>3</b>
LM End	<b>1.26</b>	Issue Type +	Ma	Location *	LS
Category	Earthen Levee		GPS Latitude/Longitude		
			Start	End	
Item	Vegetation		37.032393 °	37.045430 °	
			-120.441279 °	-120.427710 °	
DWR ID	DWR_NA0010_14_s_2016_3				
Comment Code					
V1 : Control annual grass and weeds on the levee slopes and easements.					
Inspector Comment

Looking at typical view of levee slope.

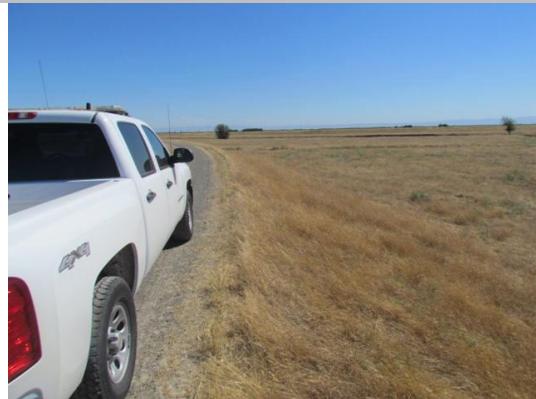
Photo 1 of 1 : SP\_2016\_NA0010\_132\_4\_20160523\_00007.jpg

LM Start	<b>0.00</b>	Rating **	M	Issue No.	<b>4</b>
LM End	<b>1.26</b>	Issue Type +	Ma	Location *	WS
Category	Earthen Levee		GPS Latitude/Longitude		
			Start	End	
Item	Vegetation		37.032394 °	37.045430 °	
			-120.441279 °	-120.427711 °	
DWR ID	DWR_NA0010_14_s_2016_4				
Comment Code					
V1 : Control annual grass and weeds on the levee slopes and easements.					
Inspector Comment

Looking at typical view of waterward slope.

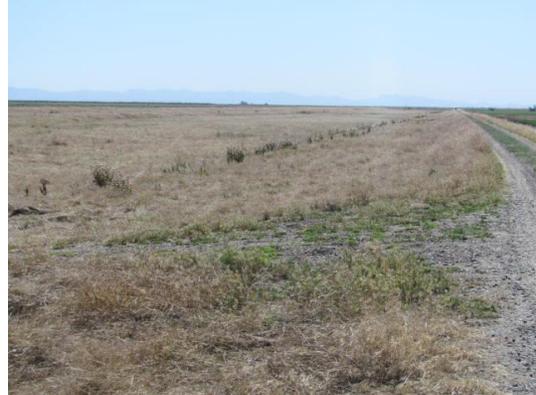
Photo 1 of 1 : SP\_2016\_NA0010\_133\_4\_20160524\_00009.jpg

LM Start	<b>0.00</b>	Rating **	M	Issue No.	<b>4</b>
LM End	<b>1.99</b>	Issue Type +	Ma	Location *	WS
Category	Earthen Levee		GPS Latitude/Longitude		
			Start	End	
Item	Vegetation		36.996606 °	36.996587 °	
			-120.410410 °	-120.374500 °	
DWR ID	DWR_NA0010_15_s_2016_4				
Comment Code					
V1 : Control annual grass and weeds on the levee slopes and easements.					
Inspector Comment

Looking at typical view of waterward slope.

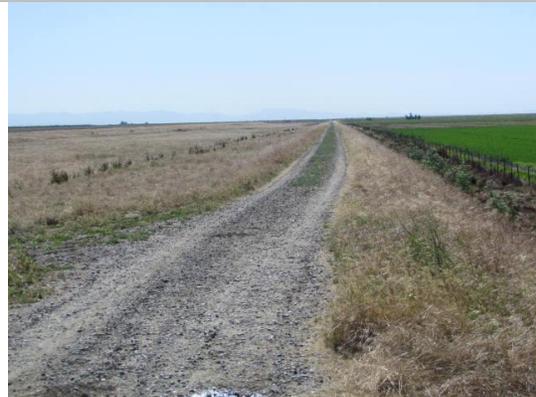
Photo 1 of 1 : SP\_2016\_NA0010\_133\_3\_20160524\_00010.jpg

LM Start	<b>0.00</b>	Rating **	M	Issue No.	<b>3</b>
LM End	<b>1.99</b>	Issue Type +	Ma	Location *	LS
Category	Earthen Levee		GPS Latitude/Longitude		
			Start	End	
Item	Vegetation		36.996606 °	36.996587 °	
			-120.410409 °	-120.374500 °	
DWR ID	DWR_NA0010_15_s_2016_3				
Comment Code					
V1 : Control annual grass and weeds on the levee slopes and easements.					
Inspector Comment

Looking at typical view of landward slope.

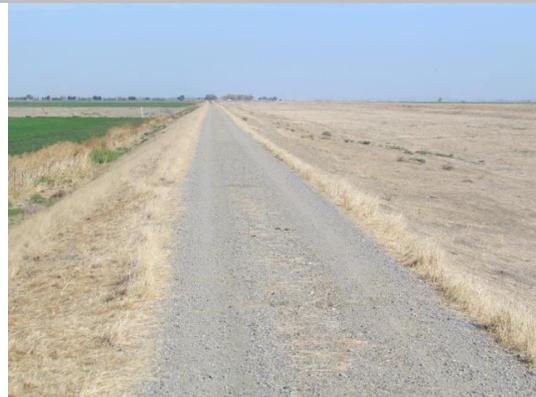
Photo 1 of 2 : SP\_2016\_NA0010\_133\_11\_20160512\_00001.jpg

LM Start	<b>0.01</b>	Rating **	M	Issue No.	<b>11</b>
LM End	<b>1.99</b>	Issue Type +	Ma	Location *	CR
Category	Earthen Levee		GPS Latitude/Longitude		
			Start	End	
Item	Crown Surface / Depressions / Rutting		36.996547 °	36.996587 °	
			-120.410220 °	-120.374503 °	
DWR ID	DWR_NA0010_15_s_2012_11				
Comment Code					
C1 : Add appropriate material and re-grade the levee to bring the crown above the design elevation.					
Inspector Comment					
Control vegetation on levee crown.

Looking east at typical view of levee in compliance with standards. Fall 2015

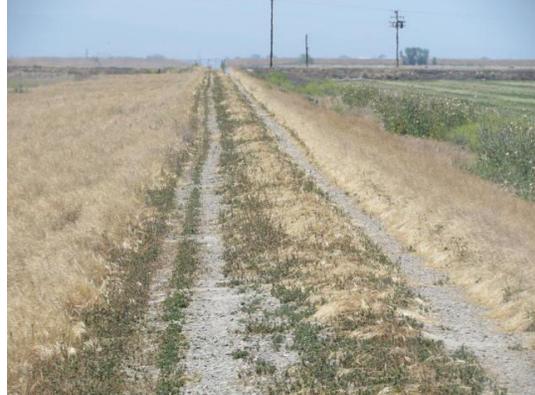
Photo 2 of 2 : SP\_2016\_NA0010\_133\_11\_20160512\_00002.jpg

LM Start	<b>0.01</b>	Rating **	M	Issue No.	<b>11 (cont)</b>
LM End	<b>1.99</b>	Issue Type +	Ma	Location *	CR
Category	Earthen Levee			GPS Latitude/Longitude	
				Start	End
Item	Crown Surface / Depressions / Rutting			36.996547 °	36.996587 °
				-120.410220 °	-120.374503 °
DWR ID	DWR_NA0010_15_s_2012_11				
Comment Code					
C1 : Add appropriate material and re-grade the levee to bring the crown above the design elevation.					
Inspector Comment					
Control vegetation on levee crown.

Looking east at vegetation on levee crown. Spring 2015

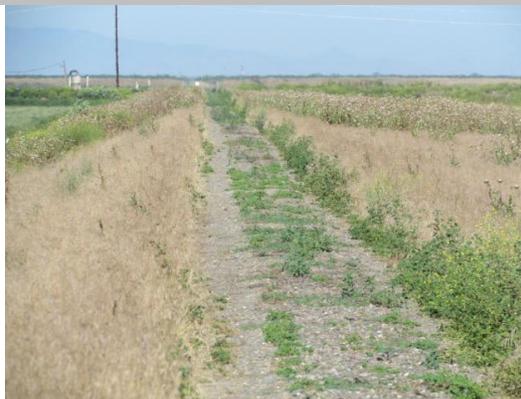
Photo 1 of 1 : SP\_2016\_NA0010\_134\_14\_20160524\_00008.jpg

LM Start	<b>0.01</b>	Rating **	M	Issue No.	<b>14</b>
LM End	<b>1.96</b>	Issue Type +	Ma	Location *	CR
Category	Earthen Levee		GPS Latitude/Longitude		
			Start	End	
Item	Crown Surface / Depressions / Rutting		36.995388 °	36.995507 °	
			-120.408738 °	-120.373592 °	
DWR ID	DWR_NA0010_16_s_2012_14				
Comment Code					
C1 : Add appropriate material and re-grade the levee to bring the crown above the design elevation.					
Inspector Comment					
Control vegetation and regrade levee crown.

Looking at typical view of levee crown.

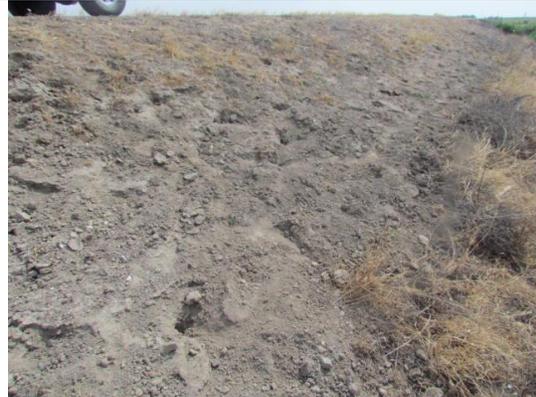
Photo 1 of 1 : SP\_2016\_NA0010\_134\_92\_20160512\_00004.jpg

LM Start	<b>0.93</b>	Rating **	M	Issue No.	<b>92</b>
LM End	<b>0.93</b>	Issue Type +	Ma	Location *	LS
Category	Earthen Levee		GPS Latitude/Longitude		
			Start	End	
Item	Animal Control		36.995439 °	36.995439 °	
			-120.392146 °	-120.392146 °	
DWR ID	DWR_NA0010_16_s_2015_92				
Comment Code					
A3 : No rodents visible, but rodent burrows visible; need to backfill and compact or grout burrows.					
Inspector Comment					
Notice several rodent holes within this section.

Looking at several rodent holes on landward slope.

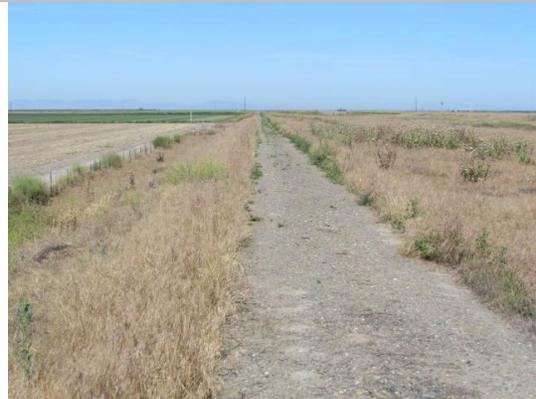
Photo 1 of 1 : SP\_2016\_NA0010\_134\_5\_20160524\_00010.jpg

LM Start	<b>1.43</b>	Rating **	U	Issue No.	<b>5</b>
LM End	<b>1.96</b>	Issue Type +	Ma	Location *	LS
Category	Earthen Levee		GPS Latitude/Longitude		
			Start	End	
Item	Vegetation		36.995466 °	36.995487 °	
			-120.383089 °	-120.373596 °	
DWR ID	DWR_NA0010_16_s_2016_5				
Comment Code					
V1 : Control annual grass and weeds on the levee slopes and easements.					
Inspector Comment

Looking west at dense veg on landward slope.
