**Flood Control Project Maintenance  
Levee Inspections**

**Maintenance Issue Types Only, Levee Inspection Report By Mile - Spring 2016**

**Lower San Joaquin Levee District**

Waterway	Bank	Unit Miles	Inspection Start/End	Inspector
Unit No. 01 San Joaquin River	Right	22.52	05/16/2016 05/19/2016	Richard Willoughby

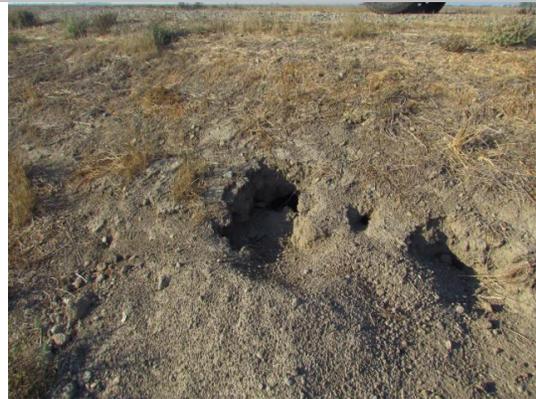
Photo 1 of 2 : SP\_2016\_NA0010\_134\_2\_20160512\_00001.jpg

LM Start	<b>1.77</b>	Rating **	U	Issue No.	<b>2</b>
LM End	<b>1.77</b>	Issue Type +	Ma	Location *	LS
Category	Earthen Levee		GPS Latitude/Longitude		
			Start	End	
Item	Animal Control		36.995487 °	36.995487 °	
			-120.377054 °	-120.377054 °	
DWR ID	DWR_NA0010_16_f_2014_2				
Comment Code					
A3 : No rodents visible, but rodent burrows visible; need to backfill and compact or grout burrows.					
Inspector Comment					
Large rodent holes on landward slope.

Looking at large rodent holes on landward slope.

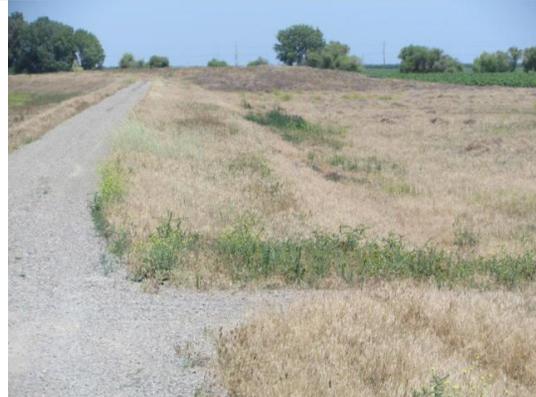
Photo 1 of 1 : SP\_2016\_NA0010\_135\_13\_20160524\_00027.jpg

LM Start	<b>0.00</b>	Rating **	M	Issue No.	<b>13</b>
LM End	<b>16.09</b>	Issue Type +	Ma	Location *	LS
Category	Earthen Levee		GPS Latitude/Longitude		
			Start	End	
Item	Vegetation		36.976460 °	36.774431 °	
			-120.374695 °	-120.283758 °	
DWR ID	DWR_NA0010_17_s_2016_13				
Comment Code					
V1 : Control annual grass and weeds on the levee slopes and easements.					
Inspector Comment

Looking at typical view of landward slope.

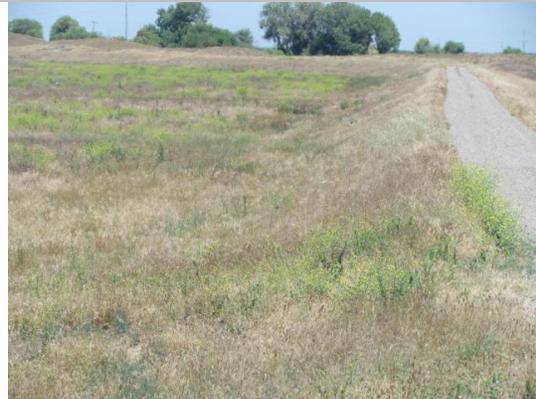
Photo 1 of 1 : SP\_2016\_NA0010\_135\_14\_20160524\_00026.jpg

LM Start	<b>0.00</b>	Rating **	M	Issue No.	<b>14</b>
LM End	<b>16.09</b>	Issue Type +	Ma	Location *	WS
Category	Earthen Levee		GPS Latitude/Longitude		
			Start	End	
Item	Vegetation		36.976460 °	36.774431 °	
			-120.374695 °	-120.283758 °	
DWR ID	DWR_NA0010_17_s_2016_14				
Comment Code					
V1 : Control annual grass and weeds on the levee slopes and easements.					
Inspector Comment

Looking at typical view of waterward slope.

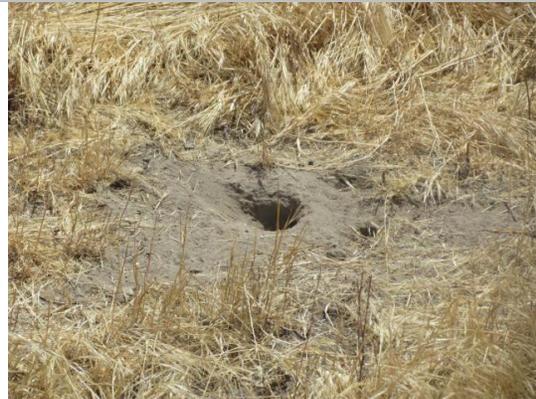
Photo 1 of 1 : SP\_2016\_NA0010\_135\_4\_20160512\_00003.jpg

LM Start	<b>6.51</b>	Rating **	M	Issue No.	<b>4</b>
LM End	<b>6.60</b>	Issue Type +	Ma	Location *	LS
Category	Earthen Levee			GPS Latitude/Longitude	
				Start	End
Item	Animal Control			36.898124 °	36.896943 °
				-120.326714 °	-120.326133 °
DWR ID	DWR_NA0010_17_s_2012_4				
Comment Code					
A1 : Exterminate rodents and backfill and compact or grout burrows.					
Inspector Comment					
Notice several rodent holes within this reach.

Looking at typical view of rodent holes on landward slope.

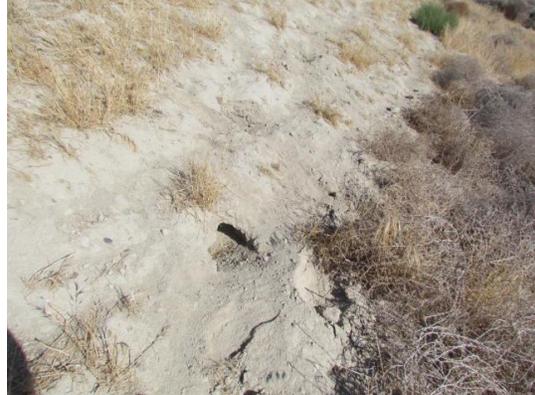
Photo 1 of 2 : SP\_2016\_NA0010\_135\_3\_20160512\_00001.jpg

LM Start	<b>12.34</b>	Rating **	M	Issue No.	<b>3</b>
LM End	<b>12.37</b>	Issue Type +	Ma	Location *	LS
Category	Earthen Levee		GPS Latitude/Longitude		
			Start	End	
Item	Animal Control		36.820558 °	36.820155 °	
			-120.300616 °	-120.300784 °	
DWR ID	DWR_NA0010_17_s_2014_3				
Comment Code					
A3 : No rodents visible, but rodent burrows visible; need to backfill and compact or grout burrows.					
Inspector Comment					
Noted several rodent holes with this reach.

Looking at typical view of rodent holes on landward slope. Fall 2015

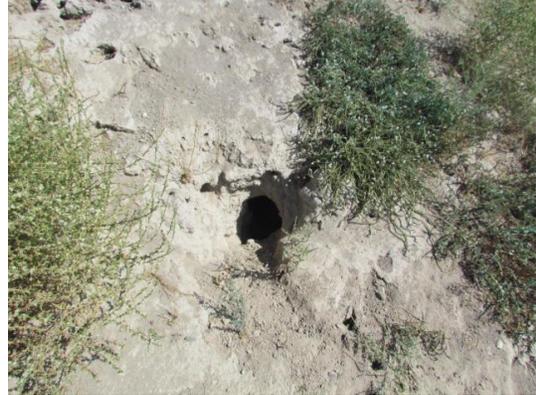
Photo 1 of 2 : SP\_2016\_NA0010\_137\_8\_20160512\_00003.jpg

LM Start	<b>2.25</b>	Rating **	U	Issue No.	<b>8</b>
LM End	<b>2.25</b>	Issue Type +	Ma	Location *	LS
Category	Earthen Levee			GPS Latitude/Longitude	
				Start	End
Item	Animal Control			36.945563 °	36.945563 °
				-120.347121 °	-120.347121 °
DWR ID	DWR_NA0010_18_f_2015_8				
Comment Code					
A3 : No rodents visible, but rodent burrows visible; need to backfill and compact or grout burrows.					
Inspector Comment					
One large rodent hole and other rodent holes within this area.

Looking at large rodent hole on landward slope.

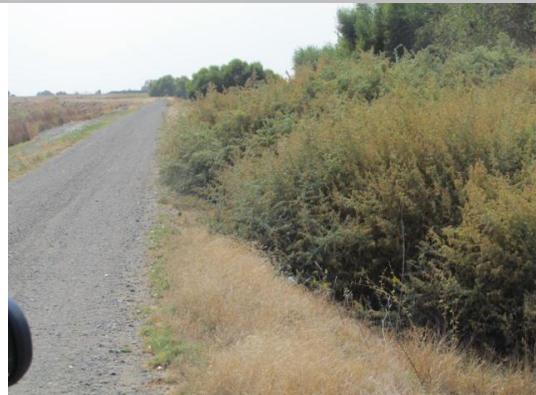
Photo 1 of 2 : SP\_2016\_NA0010\_138\_21\_20160512\_00009.jpg

LM Start	<b>0.53</b>	Rating **	U	Issue No.	<b>21</b>
LM End	<b>0.53</b>	Issue Type +	Ma	Location *	LS
Category	Earthen Levee		GPS Latitude/Longitude		
			Start	End	
Item	Vegetation		37.213006°	37.213006°	
			-120.698019°	-120.698019°	
DWR ID	DWR_NA0010_22A_f_2014_21				
Comment Code					
V2 : Remove the wild growth other than native grasses from the levee slopes.					
Inspector Comment					
Dense vegetation on landward slope.

Looking at dense vegetation on landward slope. Fall 2015

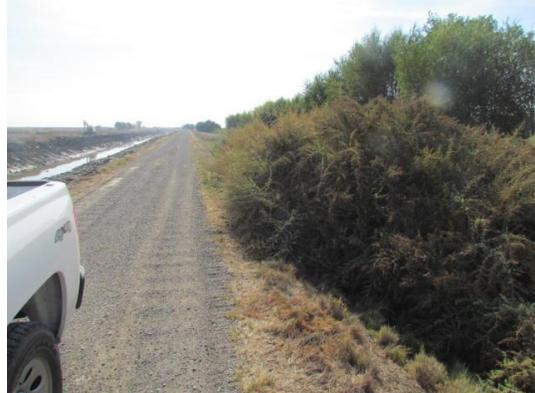
Photo 2 of 2 : SP\_2016\_NA0010\_138\_21\_20160512\_00010.jpg

LM Start	<b>0.53</b>	Rating **	U	Issue No.	<b>21 (cont)</b>
LM End	<b>0.53</b>	Issue Type +	Ma	Location *	LS
Category	Earthen Levee			GPS Latitude/Longitude	
				Start	End
Item	Vegetation			37.213006 °	37.213006 °
				-120.698019 °	-120.698019 °
DWR ID	DWR_NA0010_22A_f_2014_21				
Comment Code					
V2 : Remove the wild growth other than native grasses from the levee slopes.					
Inspector Comment					
Dense vegetation on landward slope.

Looking south at dense vegetation on landward slope. Spring 2015

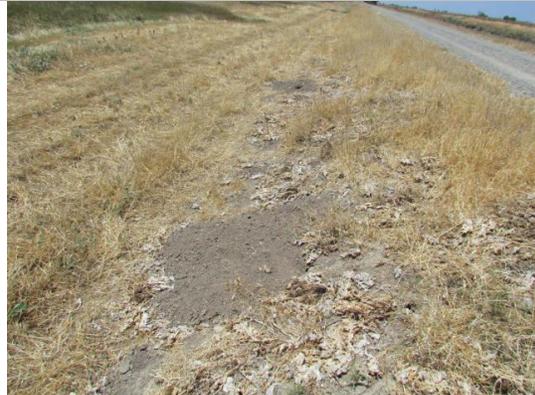
Photo 1 of 1 : SP\_2016\_NA0010\_138\_15\_20160512\_00008.jpg

LM Start	<b>2.86</b>	Rating **	M	Issue No.	<b>15</b>
LM End	<b>3.05</b>	Issue Type +	Ma	Location *	LS
Category	Earthen Levee			GPS Latitude/Longitude	
				Start	End
Item	Animal Control			37.245431 °	37.247343 °
				-120.707990 °	-120.710362 °
DWR ID	DWR_NA0010_22A_s_2014_15				
Comment Code					
A3 : No rodents visible, but rodent burrows visible; need to backfill and compact or grout burrows.					
Inspector Comment					
Noted several rodent holes on landward slope and toe.

Looking at several rodent holes on landward slope.

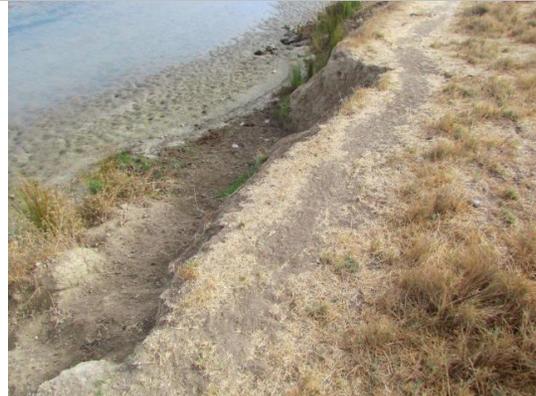
Photo 1 of 2 : SP\_2016\_NA0010\_138\_4\_20160512\_00001.jpg

LM Start	<b>5.05</b>	Rating **	M	Issue No.	<b>4</b>
LM End	<b>5.05</b>	Issue Type +	Ma	Location *	WS
Category	Earthen Levee		GPS Latitude/Longitude		
			Start	End	
Item	Erosion / Bank Caving		37.267516 °	37.267516 °	
			-120.736401 °	-120.736401 °	
DWR ID	DWR_NA0010_22A_f_2013_4				
Comment Code					
E2 : Schedule repair of erosion site prior to the next inspection.					
Inspector Comment					
Erosion caused by animal traffic.

Looking southeast at livestock erosion on waterward toe.

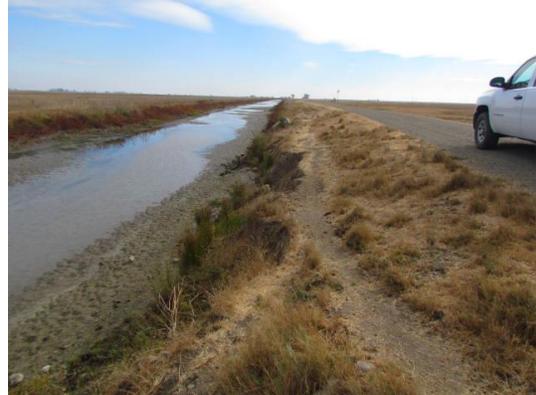
Photo 2 of 2 : SP\_2016\_NA0010\_138\_4\_20160512\_00002.jpg

LM Start	<b>5.05</b>	Rating **	M	Issue No.	<b>4 (cont)</b>
LM End	<b>5.05</b>	Issue Type +	Ma	Location *	WS
Category	Earthen Levee			GPS Latitude/Longitude	
				Start	End
Item	Erosion / Bank Caving			37.267516 °	37.267516 °
				-120.736401 °	-120.736401 °
DWR ID	DWR_NA0010_22A_f_2013_4				
Comment Code					
E2 : Schedule repair of erosion site prior to the next inspection.					
Inspector Comment					
Erosion caused by animal traffic.

Looking south livestock erosion on waterward toe.

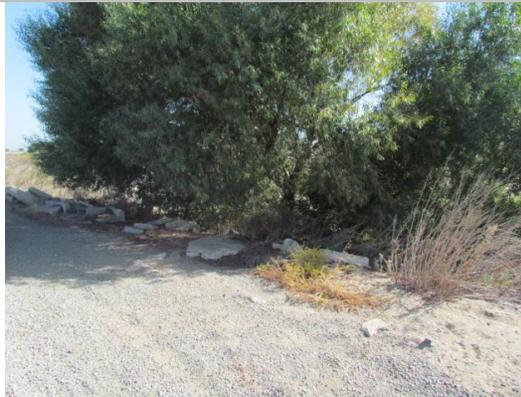
Photo 1 of 1 : SP\_2016\_NA0010\_139\_1\_20160512\_00001.jpg

LM Start	<b>1.91</b>	Rating **	U	Issue No.	<b>1</b>
LM End	<b>1.91</b>	Issue Type +	Ma	Location *	WS
Category	Earthen Levee		GPS Latitude/Longitude		
			Start	End	
Item	Trim / Thin Trees		36.772943 °	36.772943 °	
			-120.253511 °	-120.253511 °	
DWR ID	DWR_NA0010_23_s_2015_1				
Comment Code					
T1 : Trim trees to at least five feet above ground level.					
Inspector Comment					
Untrimmed tree on waterward slope

Looking at untrimmed tree on waterward slope.

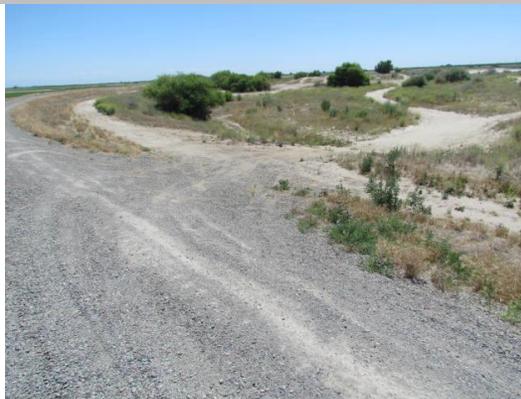
Photo 1 of 1 : SP\_2016\_NA0010\_139\_16\_20160524\_00052.jpg

LM Start	<b>2.12</b>	Rating **	M	Issue No.	<b>16</b>
LM End	<b>2.42</b>	Issue Type +	Ma	Location *	WS
Category	Earthen Levee		GPS Latitude/Longitude		
			Start	End	
Item	Slope Stability		36.775507 °	36.774423 °	
			-120.251672 °	-120.246993 °	
DWR ID	DWR_NA0010_23_s_2013_16				
Comment Code					
S3 : Repair the levee slope damaged by vehicle traffic and prevent access where possible.					
Inspector Comment					
Several damaged sites within this reach. Damage caused by vehicle traffic. At. LM. 2.12, 2.21, 2.37, & 2.41

Looking west at one of several slope damaged cause by vehicle traffic.

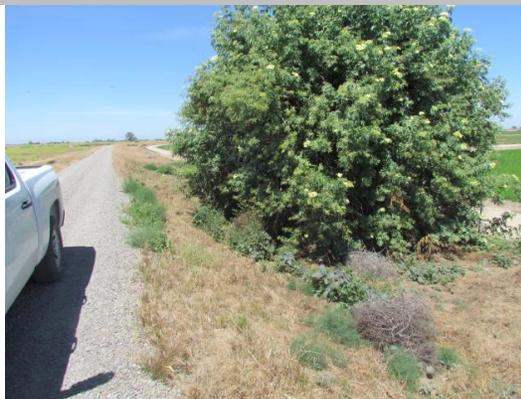
Photo 1 of 3 : SP\_2016\_NA0010\_139\_15\_20160524\_00053.jpg

LM Start	<b>2.85</b>	Rating **	U	Issue No.	<b>15</b>
LM End	<b>2.85</b>	Issue Type +	Ma	Location *	LS
Category	Earthen Levee		GPS Latitude/Longitude		
			Start	End	
Item	Vegetation		36.771537 °	36.771537 °	
			-120.240917 °	-120.240917 °	
DWR ID	DWR_NA0010_23_s_2012_15				
Comment Code					
V4 : Elderberries are blocking visibility and flood fight capability.					
Inspector Comment					
Control growth of elderberry bush on landward toe.

Looking north at elderberry at landward toe. (Spring 2016)

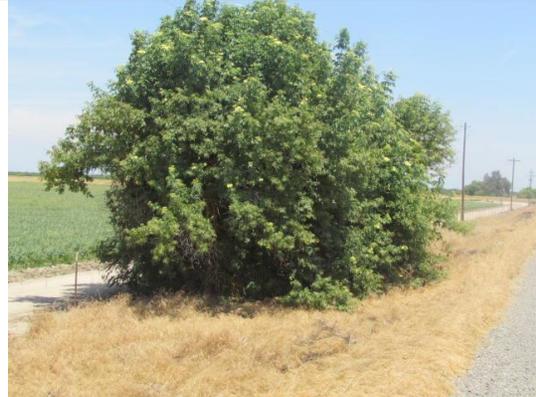
Photo 2 of 3 : SP\_2016\_NA0010\_139\_15\_20160512\_00014.jpg

LM Start	<b>2.85</b>	Rating **	U	Issue No.	<b>15 (cont)</b>
LM End	<b>2.85</b>	Issue Type +	Ma	Location *	LS
Category	Earthen Levee		GPS Latitude/Longitude		
			Start	End	
Item	Vegetation		36.771537 °	36.771537 °	
			-120.240917 °	-120.240917 °	
DWR ID	DWR_NA0010_23_s_2012_15				
Comment Code					
V4 : Elderberries are blocking visibility and flood fight capability.					
Inspector Comment					
Control growth of elderberry bush on landward toe.

Looking south at elderberry at landward toe. (Spring 2015)

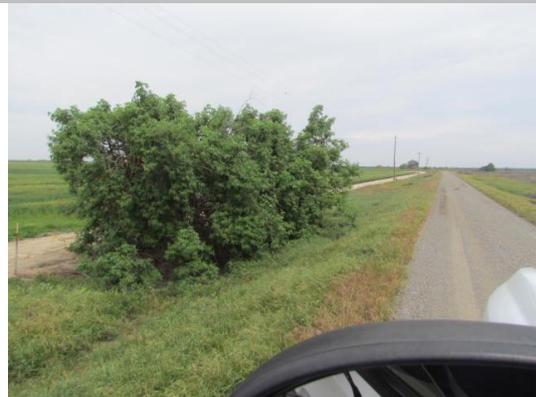
Photo 3 of 3 : SP\_2016\_NA0010\_139\_15\_20160512\_00015.jpg

Looking south at elderberry on landside toe and berm. (Fall 2014)

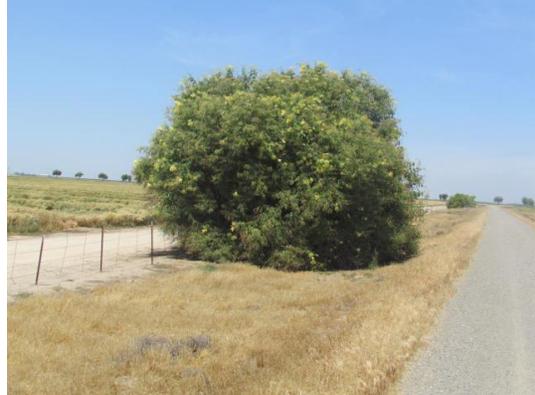
Photo 2 of 4 : SP\_2016\_NA0010\_139\_3\_20160512\_00002.jpg

LM Start	<b>3.30</b>	Rating **	U	Issue No.	<b>3</b>
LM End	<b>3.30</b>	Issue Type +	Ma	Location *	LS
Category	Earthen Levee		GPS Latitude/Longitude		
			Start	End	
Item	Vegetation		36.774403 °	36.774403 °	
			-120.234705 °	-120.234705 °	
DWR ID	DWR_NA0010_23_s_2012_3				
Comment Code					
V4 : Elderberries are blocking visibility and flood fight capability.					
Inspector Comment					
Control growth of elderberry on landward toe.

Looking south at elderberry on landward toe and berm. (Spring 2015)

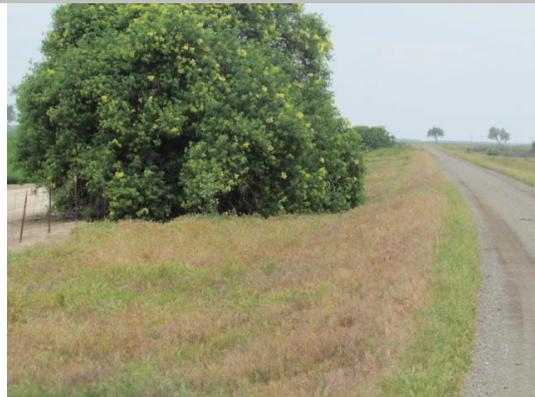
Photo 3 of 4 : SP\_2016\_NA0010\_139\_3\_20160512\_00003.jpg

Looking south at elderberry on landside toe and berm. (Fall 2014)

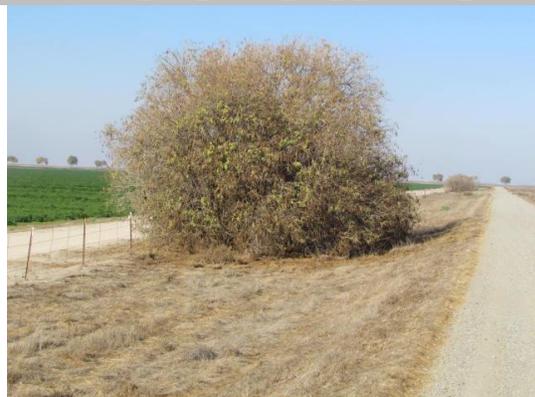
Photo 4 of 4 : SP\_2016\_NA0010\_139\_3\_20160512\_00004.jpg

Looking south at elderberry bush on landward toe. (Spring 2013)

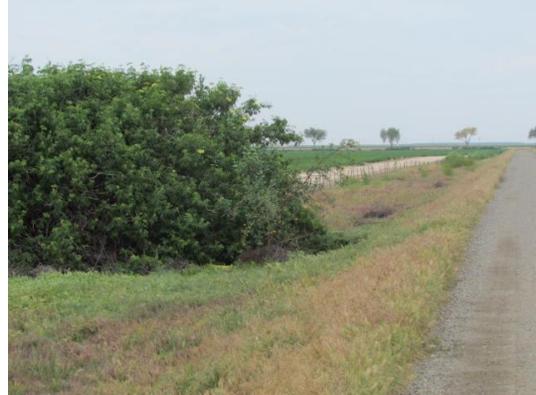
Photo 1 of 1 : SP\_2016\_NA0010\_139\_9\_20160512\_00007.jpg

LM Start	<b>3.45</b>	Rating **	M	Issue No.	<b>9</b>
LM End	<b>3.45</b>	Issue Type +	Ma	Location *	LS
Category	Earthen Levee		GPS Latitude/Longitude		
			Start	End	
Item	Vegetation		36.776537 °	36.776537 °	
			-120.234573 °	-120.234573 °	
DWR ID	DWR_NA0010_23_s_2012_9				
Comment Code					
V4 : Elderberries are blocking visibility and flood fight capability.					
Inspector Comment					
Control growth of elderberry on landward toe and berm.

Looking south at elderberry on landside toe and berm.

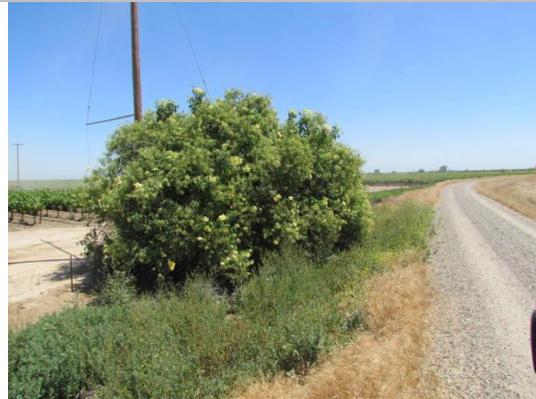
Photo 1 of 3 : SP\_2016\_NA0010\_139\_10\_20160524\_00055.jpg

LM Start	<b>4.13</b>	Rating **	U	Issue No.	<b>10</b>
LM End	<b>4.13</b>	Issue Type +	Ma	Location *	LS
Category	Earthen Levee		GPS Latitude/Longitude		
			Start	End	
Item	Vegetation		36.784212 °	36.784212 °	
			-120.228815 °	-120.228815 °	
DWR ID	DWR_NA0010_23_s_2012_10				
Comment Code					
V4 : Elderberries are blocking visibility and flood fight capability.					
Inspector Comment					
Control growth of elderberry on landward toe.

Looking south at elderberry bush on landward toe. (Spring 2016)

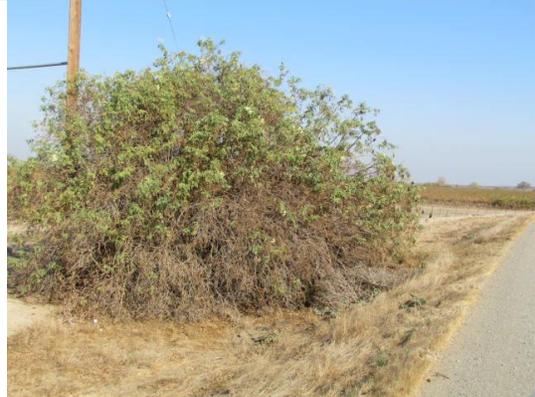
Photo 3 of 3 : SP\_2016\_NA0010\_139\_10\_20160512\_00008.jpg

LM Start	<b>4.13</b>	Rating **	U	Issue No.	<b>10 (cont)</b>
LM End	<b>4.13</b>	Issue Type +	Ma	Location *	LS
Category	Earthen Levee		GPS Latitude/Longitude		
			Start	End	
Item	Vegetation		36.784212 °	36.784212 °	
			-120.228815 °	-120.228815 °	
DWR ID	DWR_NA0010_23_s_2012_10				
Comment Code					
V4 : Elderberries are blocking visibility and flood fight capability.					
Inspector Comment					
Control growth of elderberry on landward toe.

Looking south at elderberry bush on landward toe. (Fall 2013)

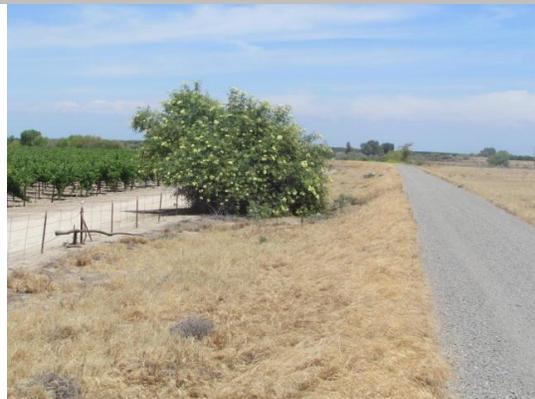
Photo 1 of 2 : SP\_2016\_NA0010\_139\_11\_20160512\_00010.jpg

LM Start	<b>4.45</b>	Rating **	M	Issue No.	<b>11</b>
LM End	<b>4.45</b>	Issue Type +	Ma	Location *	LS
Category	Earthen Levee		GPS Latitude/Longitude		
			Start	End	
Item	Vegetation		36.784523 °	36.784523 °	
			-120.223292 °	-120.223292 °	
DWR ID	DWR_NA0010_23_s_2012_11				
Comment Code					
V4 : Elderberries are blocking visibility and flood fight capability.					
Inspector Comment					
Control growth of elderberry on landward toe and berm.

Looking south at elderberry on landward toe and berm. (Spring 2015)

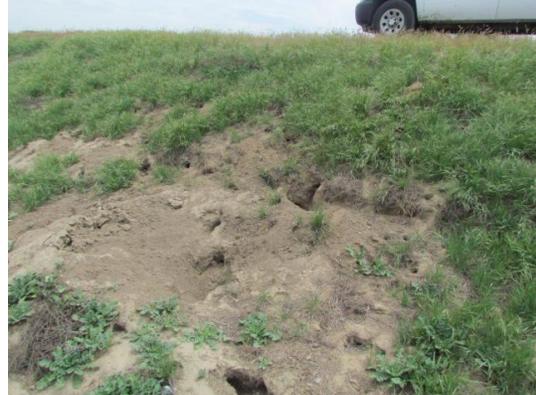
Photo 1 of 1 : SP\_2016\_NA0010\_139\_5\_20160512\_00005.jpg

LM Start	<b>5.68</b>	Rating **	U	Issue No.	<b>5</b>
LM End	<b>5.68</b>	Issue Type +	Ma	Location *	WS
Category	Earthen Levee		GPS Latitude/Longitude		
			Start	End	
Item	Animal Control		36.791981 °	36.791981 °	
			-120.206274 °	-120.206274 °	
DWR ID	DWR_NA0010_23_s_2012_5				
Comment Code					
A1 : Exterminate rodents and backfill and compact or grout burrows.					
Inspector Comment					
Several large rodent holes in this area.

Looking at several rodent holes on landside slope.

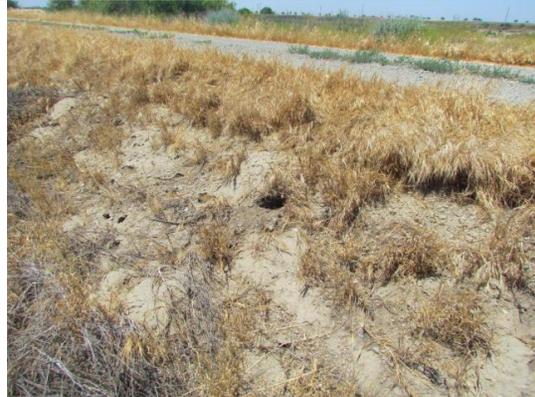
Photo 1 of 1 : SP\_2016\_NA0010\_140\_7\_20160512\_00006.jpg

LM Start	<b>3.46</b>	Rating **	M	Issue No.	<b>7</b>
LM End	<b>3.46</b>	Issue Type +	Ma	Location *	LS
Category	Earthen Levee		GPS Latitude/Longitude		
			Start	End	
Item	Animal Control		36.769345 °	36.769345 °	
			-120.238370 °	-120.238370 °	
DWR ID	DWR_NA0010_24_s_2012_7				
Comment Code					
A3 : No rodents visible, but rodent burrows visible; need to backfill and compact or grout burrows.					
Inspector Comment					
One of several rodent holes on landward slope.

Looking east at one of several rodent holes on landward slope.

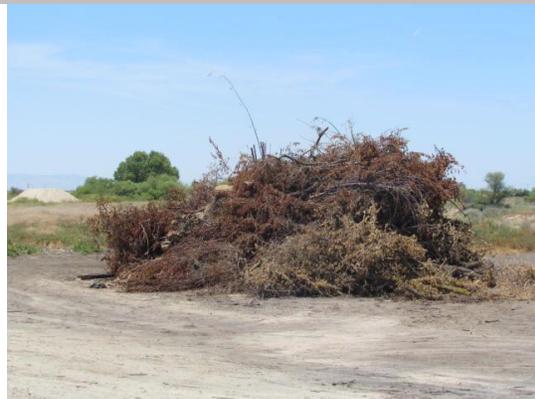
Photo 1 of 1 : SP\_2016\_NA0010\_140\_3\_20160524\_00036.jpg

LM Start	<b>6.33</b>	Rating **	U	Issue No.	<b>3</b>
LM End	<b>6.33</b>	Issue Type +	Ma	Location *	WS
Category	Earthen Levee		GPS Latitude/Longitude		
			Start	End	
Item	Encroachments		36.788155 °	36.788155 °	
			-120.209655 °	-120.209655 °	
DWR ID	DWR_NA0010_24_s_2012_3				
Comment Code					
PR : Prunings					
Inspector Comment					
Large pruning pile in channel.

Looking east at pruning pile on waterward berm.

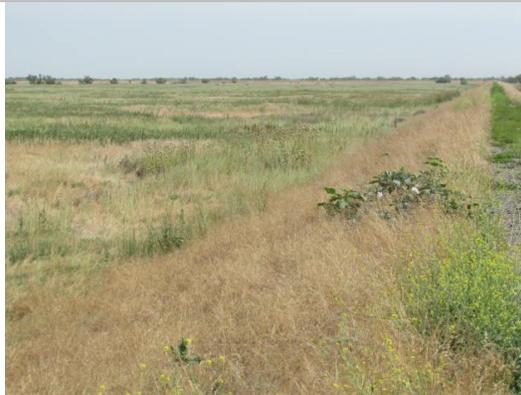
Photo 1 of 1 : SP\_2016\_NA0010\_141\_7\_20160524\_00022.jpg

LM Start	<b>0.00</b>	Rating **	U	Issue No.	<b>7</b>
LM End	<b>2.48</b>	Issue Type +	Ma	Location *	LS
Category	Earthen Levee		GPS Latitude/Longitude		
			Start	End	
Item	Vegetation		37.296261 °	37.271165 °	
			-120.880678 °	-120.866629 °	
DWR ID	DWR_NA0010_25_f_2015_7				
Comment Code					
V2 : Remove the wild growth other than native grasses from the levee slopes.					
Inspector Comment

Looking at typical view of landward slope.

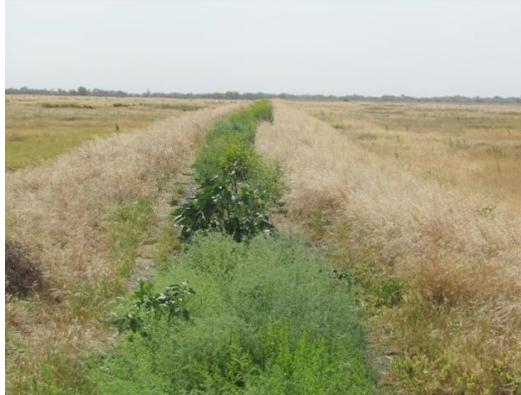
Photo 1 of 1 : SP\_2016\_NA0010\_141\_9\_20160524\_00023.jpg

LM Start	<b>0.00</b>	Rating **	U	Issue No.	<b>9</b>
LM End	<b>2.49</b>	Issue Type +	Ma	Location *	WS
Category	Earthen Levee		GPS Latitude/Longitude		
			Start	End	
Item	Vegetation		37.296261 °	37.271117 °	
			-120.880678 °	-120.866599 °	
DWR ID	DWR_NA0010_25_f_2015_9				
Comment Code					
V2 : Remove the wild growth other than native grasses from the levee slopes.					
Inspector Comment

Looking at typical view of waterward slope.

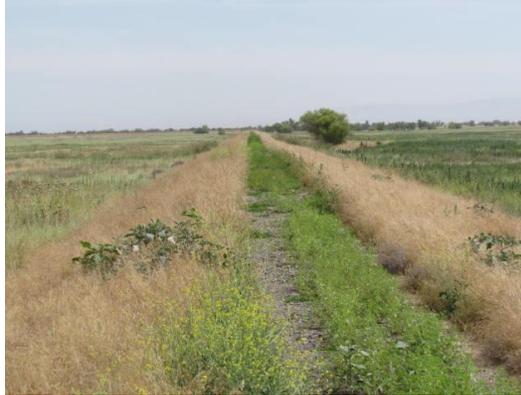
Photo 1 of 1 : SP\_2016\_NA0010\_141\_8\_20160524\_00024.jpg

LM Start	<b>0.01</b>	Rating **	U	Issue No.	<b>8</b>
LM End	<b>2.49</b>	Issue Type +	Ma	Location *	CR
Category	Earthen Levee		GPS Latitude/Longitude		
			Start	End	
Item	Vegetation		37.296117 °	37.271117 °	
			-120.880724 °	-120.866599 °	
DWR ID	DWR_NA0010_25_s_2012_8				
Comment Code					
V2 : Remove the wild growth other than native grasses from the levee slopes.					
Inspector Comment					
Control weeds on levee crown.

Looking at typical view of levee crown.
