**Flood Control Project Maintenance
Levee Inspections**

Maintenance Issue Types Only, Levee Inspection Report By Mile - Spring 2017

Lower San Joaquin Levee District

Waterway	Bank	Unit Miles	Inspection Start/End	Inspector
Unit No. 01 San Joaquin River	Right	22.52	04/17/2017 04/20/2017	Richard Willoughby

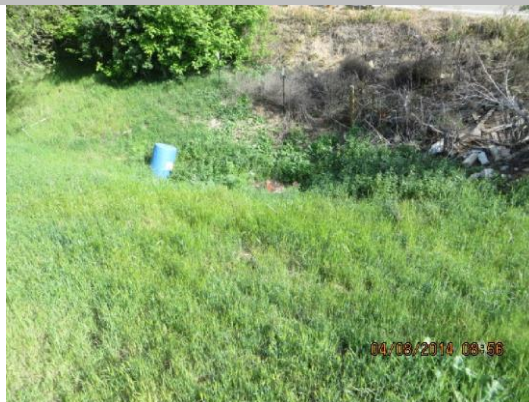
Photo 1 of 3 : UCIP_SP_2017_39091_60601.jpg

Comment Code					
Inspector Comment					
FS_ID:39091 DS_ID:19650 EP_NO: N/A Repair Type: Non-Urgent Crossing Status: Found UCIP Comments: Dense vegetation limits the inspector's visibility to identify signs of pipe failure (leaks) along the waterward slope and landward toe. Recommend removing vegetation along pipe alignment and landward toe to conduct proper inspection of structure and appurtenances. FIELD_STRUCT_DESC: 24-inch CM stormdrain pipe through the levee, 10.5 feet below the crown. Flap gate on the waterward end. Brass cap No. 108 BM on headwall on the landward side. (USACE-1967). This entry matches the Drainage or Irrigation Structure referenced in O&M manual (HLM 0.02). FS Date: 4/8/2014 7:34:00 AM

Flapgate on WS toe.

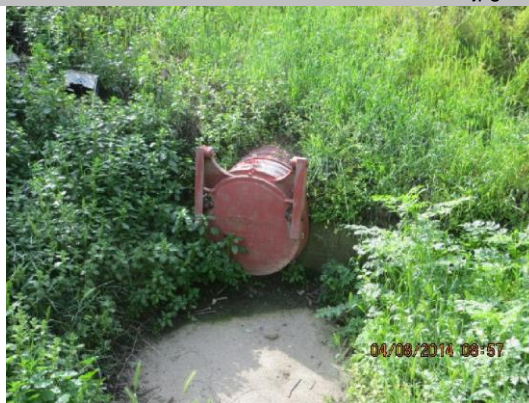
Photo 2 of 3 : UCIP_SP_2017_39091_60600.jpg

FS_ID:39091
DS_ID:19650
EP_NO: N/A
Repair Type: Non-Urgent
Crossing Status: Found
UCIP Comments: Dense vegetation limits the inspector's visibility to identify signs of pipe failure (leaks) along the waterward slope and landward toe. Recommend removing vegetation along pipe alignment and landward toe to conduct proper inspection of structure and appurtenances.
FIELD_STRUCT_DESC: 24-inch CM stormdrain pipe through the levee, 10.5 feet below the crown. Flap gate on the waterward end. Brass cap No. 108 BM on headwall on the landward side. (USACE-1967). This entry matches the Drainage or Irrigation Structure referenced in O&M manual (HLM 0.02).
FS Date: 4/8/2014 7:34:00 AM

Flapgate on WS toe.

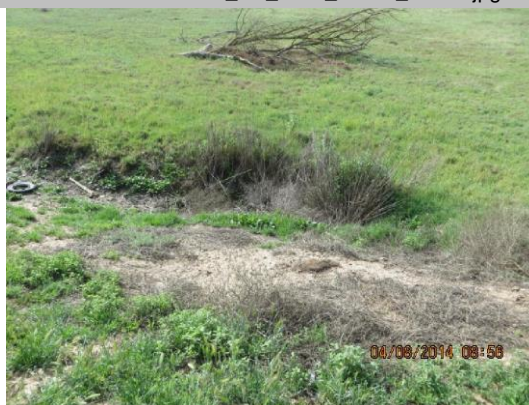
Photo 3 of 3 : UCIP_SP_2017_39091_60602.jpg

Headwall on LS toe.

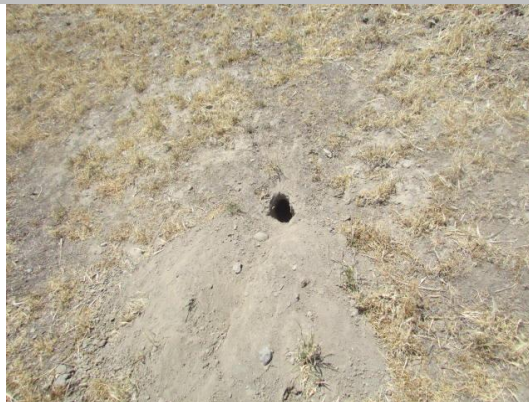
Photo 1 of 1 : SP_2017_NA0010_118_1_20170417_00001.jpg

LM Start	0.23	Rating **	M	Issue No.	1
LM End	0.23	Issue Type +	Ma	Location *	LS
Category	Earthen Levee			GPS Latitude/Longitude	
				Start	End
Item	Animal Control			37.346096 °	37.346096 °
				-120.961455 °	-120.961455 °
DWR ID	DWR_NA0010_01_s _ 2012_1				
Comment Code					
A1 : Exterminate rodents and backfill and compact or grout burrows.					
Inspector Comment					
Typical view of several rodent holes on landward slope.Could not see rodent holes due to dense vegetation.

Looking at typical rodent holes on landward slope.

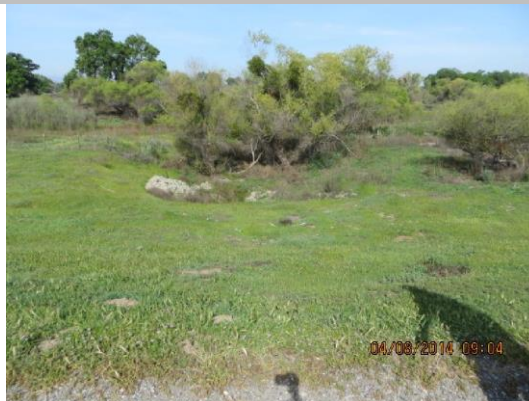
Photo 1 of 3 : UCIP_SP_2017_39092_60611.jpg

LM Start	0.34	Rating **	M	Issue No.	1186
LM End	0.34	Issue Type +	Ma	Location *	LS
Category	Supplemental			GPS Latitude/Longitude	
				Start	End
Item	DWR UCIP LMA Responsibility			37.344705 °	37.344705 °
				-120.962176 °	-120.962176 °
DWR ID					
Comment Code					
Inspector Comment					
FS_ID:39092 DS_ID:19651 EP_NO: N/A Repair Type: Non-Urgent Crossing Status: Found UCIP Comments: Pipe has significant sediment buildup and shows some signs of corrosion at landward toe. Recommend cleaning sediment from inside pipe and check wall integrity. FIELD_STRUCT_DESC: 36-inch CM stormdrain pipe through the levee, 18.5 feet below the crown. Flap gate on the waterward end. Brass cap No. 108 BM on headwall on the landward side. (USACE-1967). This entry matches the Drainage or Irrigation Structure referenced in O&M manual (HLM 0.35). FS Date: 4/8/2014

Flapgate and headwall visible off WS toe.

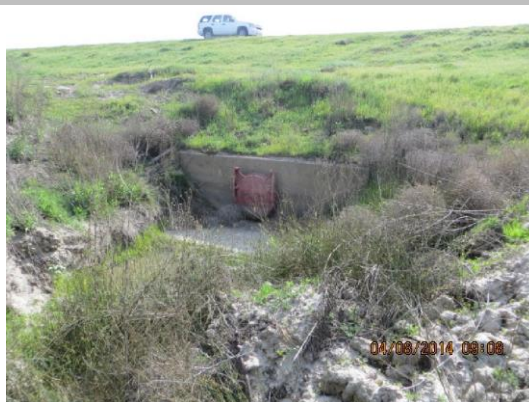
Photo 2 of 3 : UCIP_SP_2017_39092_60613.jpg

Flapgate and headwall visible off WS toe.

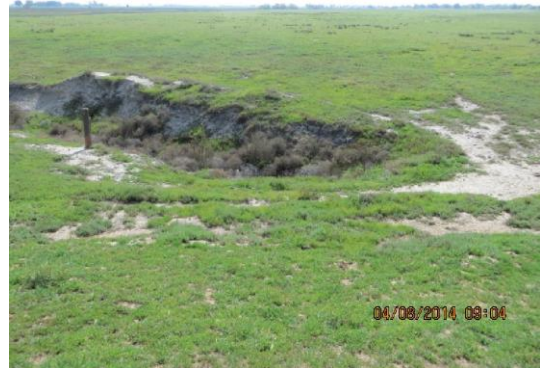
Photo 3 of 3 : UCIP_SP_2017_39092_60612.jpg

LM Start	0.34	Rating **	M	Issue No.	1186 (cont)
LM End	0.34	Issue Type +	Ma	Location *	LS
Category	Supplemental			GPS Latitude/Longitude	
				Start	End
Item	DWR UCIP LMA Responsibility			37.344705 °	37.344705 °
				-120.962176 °	-120.962176 °
DWR ID					
Comment Code					
Inspector Comment					
FS_ID:39092 DS_ID:19651 EP_NO: N/A Repair Type: Non-Urgent Crossing Status: Found UCIP Comments: Pipe has significant sediment buildup and shows some signs of corrosion at landward toe. Recommend cleaning sediment from inside pipe and check wall integrity. FIELD_STRUCT_DESC: 36-inch CM stormdrain pipe through the levee, 18.5 feet below the crown. Flap gate on the waterward end. Brass cap No. 108 BM on headwall on the landward side. (USACE-1967). This entry matches the Drainage or Irrigation Structure referenced in O&M manual (HLM 0.35). FS Date: 4/8/2014

Pipe and headwall visible off LS toe.

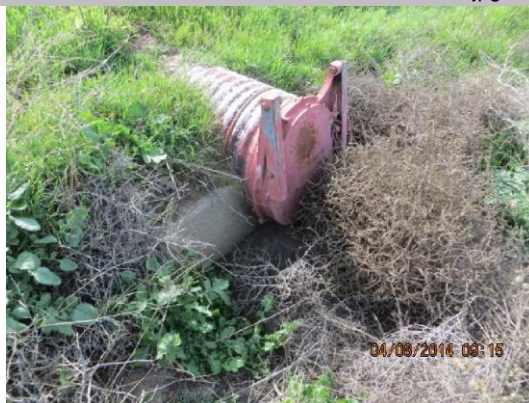
Photo 2 of 3 : UCIP_SP_2017_39095_60623.jpg

LM Start	0.60	Rating **	M	Issue No.	1187 (cont)
LM End	0.60	Issue Type +	Ma	Location *	LS
Category	Supplemental			GPS Latitude/Longitude	
				Start	End
Item	DWR UCIP LMA Responsibility			37.341507 °	37.341507 °
				-120.961283 °	-120.961283 °
DWR ID					
Comment Code					
Inspector Comment					
FS_ID:39095 DS_ID:19583 EP_NO: N/A Repair Type: Non-Urgent Crossing Status: Found UCIP Comments: Recommend removing vegetation pile from waterward toe. FIELD_STRUCT_DESC: 24-inch CM stormdrain pipe through the levee, 8.5 feet below the crown. Flap gate on the waterward end. Brass cap No. 108 BM on headwall on the landward side. (USACE-1967). This entry matches the Drainage or Irrigation Structure referenced in O&M manual (HLM 0.62). FS Date: 4/8/2014

Flapgate and headwall visible on WS toe.

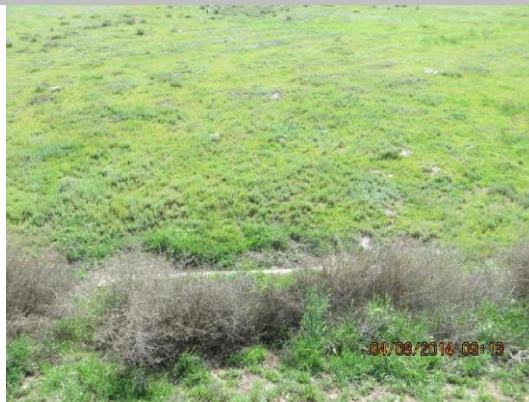
Photo 3 of 3 : UCIP_SP_2017_39095_60621.jpg

Pipe and headwall visible on LS toe.

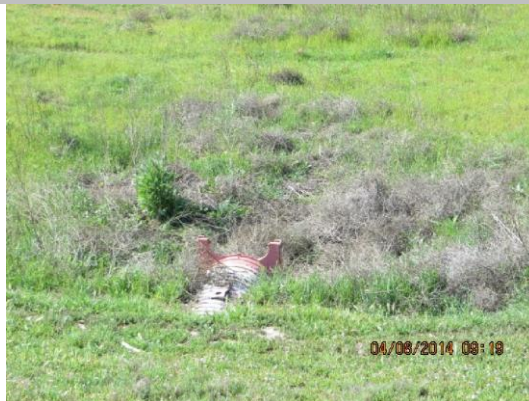
Photo 1 of 3 : UCIP_SP_2017_33524_60627.jpg

LM Start	0.85	Rating **	A/W	Issue No.	1188
LM End	0.85	Issue Type +	Ma	Location *	LS
Category	Supplemental			GPS Latitude/Longitude	
				Start	End
Item	DWR UCIP LMA Responsibility			37.339829 °	37.339829 °
				-120.958621 °	-120.958621 °
DWR ID					
Comment Code					
Inspector Comment					
FS_ID:33524					
DS_ID:19584					
EP_NO: N/A					
Repair Type: No Action Needed					
Crossing Status: Found					
UCIP Comments:					
FIELD_STRUCT_DESC: 24-inch CM pipe through the levee, 7-feet below the crown. Flap gate on the waterward end. Brass cap No. 108 BM on headwall on the landward side. (USACE-1967). This entry matches the Drainage or Irrigation Structure referenced in O&M manual (HLM 0.87).					
FS Date: 4/8/2014

Pipe, flapgate, and headwall visible on WS toe.

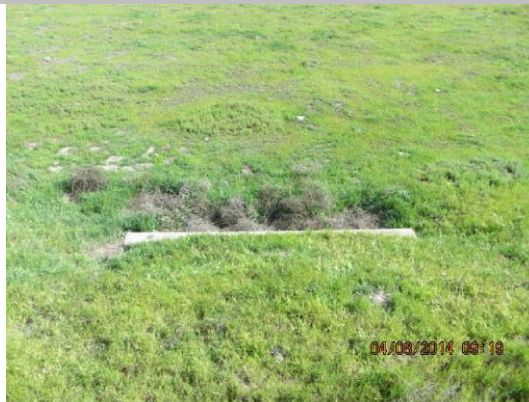
Photo 2 of 3 : UCIP_SP_2017_33524_60626.jpg

Pipe and headwall visible on LS toe.

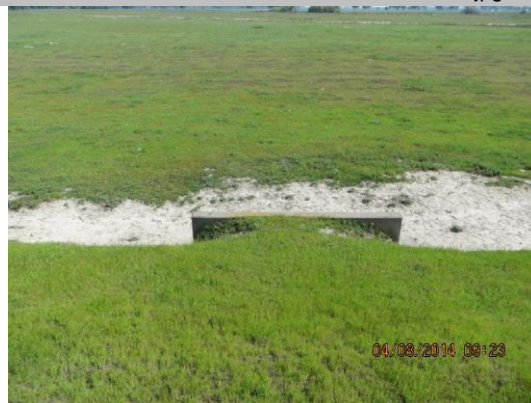
Photo 2 of 3 : UCIP_SP_2017_39096_60631.jpg

LM Start	0.93	Rating **	M	Issue No.	1189 (cont)	
LM End	0.93	Issue Type +	Ma	Location *	LS	
Category	Supplemental			GPS Latitude/Longitude		
				Start		End
Item	DWR UCIP LMA Responsibility			37.339598 °		37.339598 °
				-120.957202 °		-120.957202 °
DWR ID						
Comment Code						
Inspector Comment						
FS_ID:39096 DS_ID:19585 EP_NO: N/A Repair Type: Non-Urgent Crossing Status: Found UCIP Comments: Moderate erosion around headwall on landward toe. May or may not be an issue. Need to contact owner to determine status of crossing and to address erosion issue on landward side. FIELD_STRUCT_DESC: 24-inch CM pipe through the levee, 7-feet below the crown. Flap gate on the waterward end. Brass cap No. 108 BM on headwall on the landward side. (USACE-1967). This entry matches the Drainage or Irrigation Structure referenced in O&M manual (HLM 0.95). FS Date: 4/8/2014

Concrete headwall and pipe visible at LS toe.

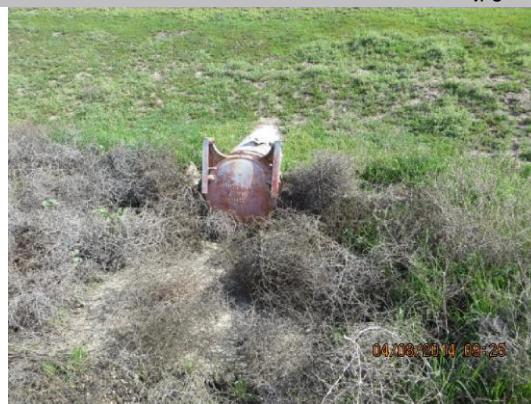
Photo 3 of 3 : UCIP_SP_2017_39096_60633.jpg

Flapgate, pipe, and headwall on WS toe.

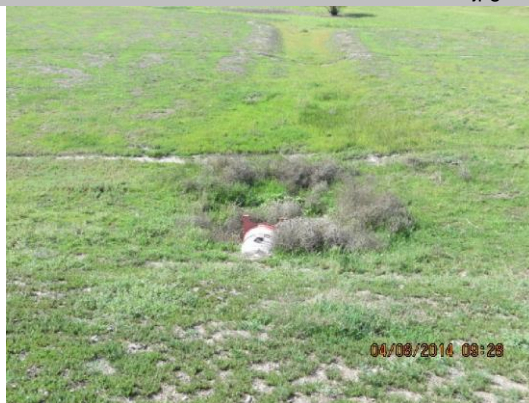
Photo 1 of 3 : UCIP_SP_2017_33543_60642.jpg

LM Start	1.15	Rating **	A/W	Issue No.	1190
LM End	1.15	Issue Type +	Ma	Location *	LS
Category	Supplemental			GPS Latitude/Longitude	
				Start	End
Item	DWR UCIP LMA Responsibility			37.338005 °	37.338005 °
				-120.953921 °	-120.953921 °
DWR ID					
Comment Code					
Inspector Comment					
FS_ID:33543					
DS_ID:19586					
EP_NO: N/A					
Repair Type: No Action Needed					
Crossing Status: Found					
UCIP Comments:					
FIELD_STRUCT_DESC: 24-inch CM stormdrain pipe through the levee, 7.5 feet below the crown. Flap gate on the waterward end. Brass cap No. 108 BM on headwall on the landward side. (USACE-1967). This entry matches the Drainage or Irrigation Structure referenced in O&M manual (HLM 1.17).					
FS Date: 4/8/2014

Pipe, headwall, and flapgate visible on WS toe.

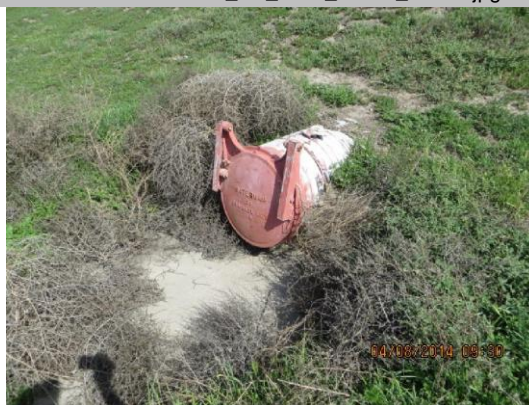
Photo 2 of 3 : UCIP_SP_2017_33543_60643.jpg

Pipe, headwall, and flapgate visible on WS toe.

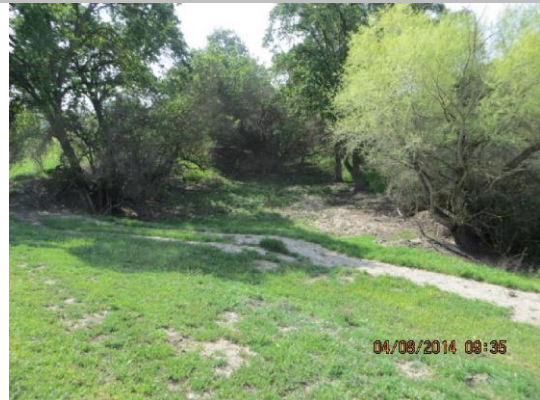
Photo 1 of 3 : UCIP_SP_2017_33544_60649.jpg

LM Start	1.32	Rating **	A/W	Issue No.	1191
LM End	1.32	Issue Type +	Ma	Location *	LS
Category	Supplemental			GPS Latitude/Longitude	
				Start	End
Item	DWR UCIP LMA Responsibility			37.337361 °	37.337361 °
				-120.950879 °	-120.950879 °
DWR ID					
Comment Code					
Inspector Comment					
FS_ID:33544 DS_ID:19587 EP_NO: N/A Repair Type: No Action Needed Crossing Status: Found UCIP Comments: FIELD_STRUCT_DESC: 36-inch CM stormdrain pipe through the levee, 12.8 feet below the crown. Flap gate on the waterward end. Brass cap No. 108 BM on headwall on the landward side. (USACE-1967). This entry matches the Drainage or Irrigation Structure referenced in O&M manual (HLM 1.34). Pipe crosses through levee at about a 45 degree angle to crown. FS Date: 4/8/2014

Concrete headwall and flapgate visible at WS toe.

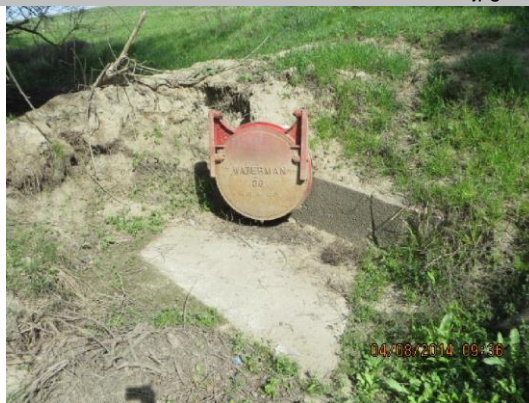
Photo 2 of 3 : UCIP_SP_2017_33544_60648.jpg

LM Start	1.32	Rating **	A/W	Issue No.	1191 (cont)	
LM End	1.32	Issue Type +	Ma	Location *	LS	
Category	Supplemental			GPS Latitude/Longitude		
				Start		End
Item	DWR UCIP LMA Responsibility			37.337361 °	37.337361 °	
				-120.950879 °	-120.950879 °	
DWR ID						
Comment Code						
Inspector Comment						
FS_ID:33544 DS_ID:19587 EP_NO: N/A Repair Type: No Action Needed Crossing Status: Found UCIP Comments: FIELD_STRUCT_DESC: 36-inch CM stormdrain pipe through the levee, 12.8 feet below the crown. Flap gate on the waterward end. Brass cap No. 108 BM on headwall on the landward side. (USACE-1967). This entry matches the Drainage or Irrigation Structure referenced in O&M manual (HLM 1.34). Pipe crosses through levee at about a 45 degree angle to crown. FS Date: 4/8/2014

Concrete headwall and flapgate visible at WS toe.

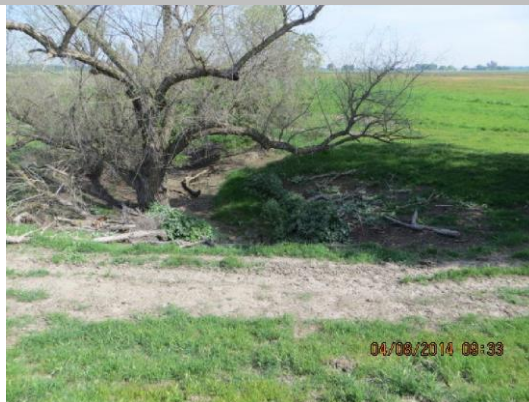
Photo 3 of 3 : UCIP_SP_2017_33544_60647.jpg

Concrete headwall and pipe visible at LS toe.

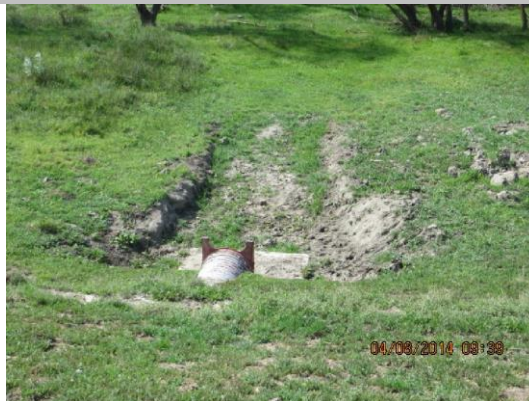
Photo 1 of 3 : UCIP_SP_2017_39099_60652.jpg

LM Start	1.46	Rating **	M	Issue No.	1192
LM End	1.46	Issue Type +	Ma	Location *	LS
Category	Supplemental			GPS Latitude/Longitude	
				Start	End
Item	DWR UCIP LMA Responsibility			37.336866 °	37.336866 °
				-120.948520 °	-120.948520 °
DWR ID					
Comment Code					
Inspector Comment					
FS_ID:39099					
DS_ID:19588					
EP_NO: N/A					
Repair Type: Non-Urgent					
Crossing Status: Found					
UCIP Comments: Some sediment buildup inside pipe at LS toe.					
Recommend contacting owner to clear sediment buildup and check wall integrity through pipe section.					
FIELD_STRUCT_DESC: 24-inch CM stormdrain pipe through the levee, 11.0 feet below the crown. Flap gate on the waterward end. Brass cap No. 108 BM on headwall on the landward side. (USACE-1967). This entry matches the Drainage or Irrigation Structure referenced in O&M manual (HLM 1.48).					
FS Date: 4/8/2014

Pipe, flapgate, and concrete headwall visible on WS toe.

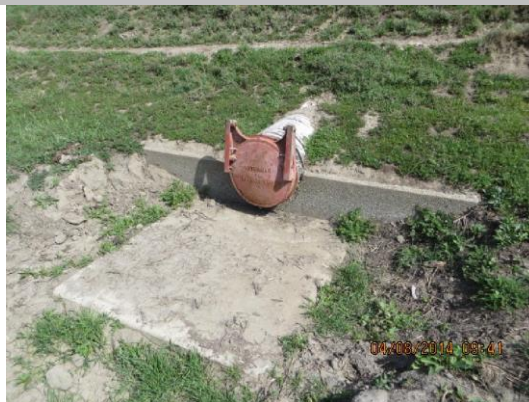
Photo 2 of 3 : UCIP_SP_2017_39099_60653.jpg

Pipe, flapgate, and concrete headwall visible on WS toe.

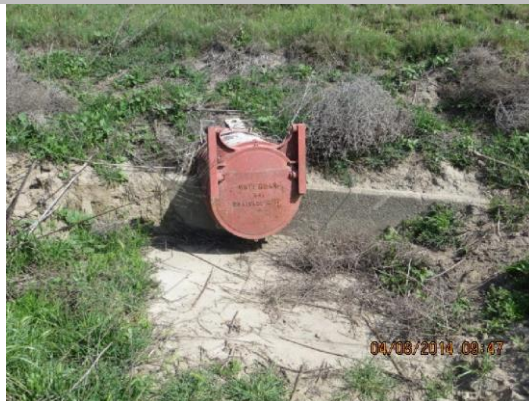
Photo 2 of 3 : UCIP_SP_2017_33563_60663.jpg

LM Start	1.67	Rating **	M	Issue No.	1193 (cont)	
LM End	1.67	Issue Type +	Ma	Location *	LS	
Category	Supplemental			GPS Latitude/Longitude		
				Start	End	
Item	DWR UCIP LMA Responsibility			37.336459 °	37.336459 °	
				-120.944803 °	-120.944803 °	
DWR ID						
Comment Code						
Inspector Comment						
FS_ID:33563 DS_ID:19589 EP_NO: N/A Repair Type: Non-Urgent Crossing Status: Found UCIP Comments: Heavy sediment buildup in pipe at LS toe. FIELD_STRUCT_DESC: 24-inch CM stormdrain pipe through the levee, 13.6 feet below the crown. Flap gate on the waterward end. Brass cap No. 100 BM on headwall on the landward side. (USACE-1967). This entry matches the Drainage or Irrigation Structure referenced in O&M manual (HLM 1.69). FS Date: 4/8/2014

Pipe, headwall, and flapgate visible on WS toe.

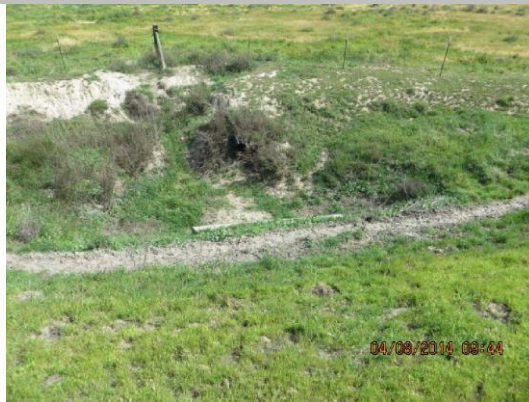
Photo 3 of 3 : UCIP_SP_2017_33563_60662.jpg

Pipe and headwall visible on LS toe.

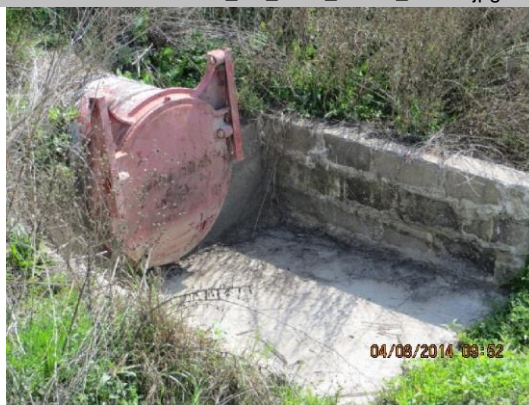
Photo 2 of 3 : UCIP_SP_2017_33564_60667.jpg

Pipe, flapgate, and headwall visible at WS toe.

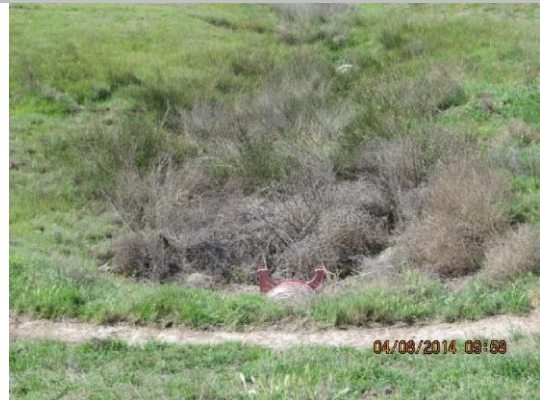
Photo 1 of 3 : UCIP_SP_2017_39100_60670.jpg

LM Start	1.95	Rating **	M	Issue No.	1195
LM End	1.95	Issue Type +	Ma	Location *	LS
Category	Supplemental			GPS Latitude/Longitude	
				Start	End
Item	DWR UCIP LMA Responsibility			37.334377 °	37.334377 °
				-120.940397 °	-120.940397 °
DWR ID					
Comment Code					
Inspector Comment					
FS_ID:39100 DS_ID:19591 EP_NO: N/A Repair Type: Non-Urgent Crossing Status: Found UCIP Comments: Need to contact owner to determine crossing status. Inlet drop box silted in and needs to be cleaned out. FIELD_STRUCT_DESC: 24-inch CM stormdrain pipe through the levee, 9.7 feet below the crown. Flap gate on the waterward end. Brass cap No. 100 BM on headwall on the landward side. (USACE-1967). Wooden barrier around drop inlet on LS toe. This entry matches the Drainage or Irrigation Structure referenced in O&M manual (HLM 1.98). FS Date: 4/8/2014

Concrete headwall and flapgate on WS toe.

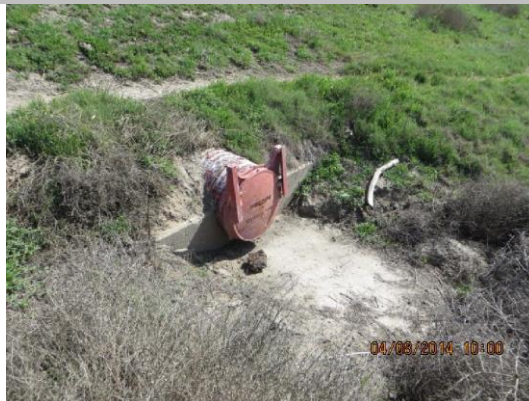
Photo 2 of 3 : UCIP_SP_2017_39100_60672.jpg

FS_ID:39100
DS_ID:19591
EP_NO: N/A
Repair Type: Non-Urgent
Crossing Status: Found
UCIP Comments: Need to contact owner to determine crossing status.
Inlet drop box silted in and needs to be cleaned out.
FIELD_STRUCT_DESC: 24-inch CM stormdrain pipe through the levee, 9.7 feet below the crown. Flap gate on the waterward end. Brass cap No. 100 BM on headwall on the landward side. (USACE-1967).
Wooden barrier around drop inlet on LS toe. This entry matches the Drainage or Irrigation Structure referenced in O&M manual (HLM 1.98).
FS Date: 4/8/2014

Pipe, flapgate, and headwall on WS toe.

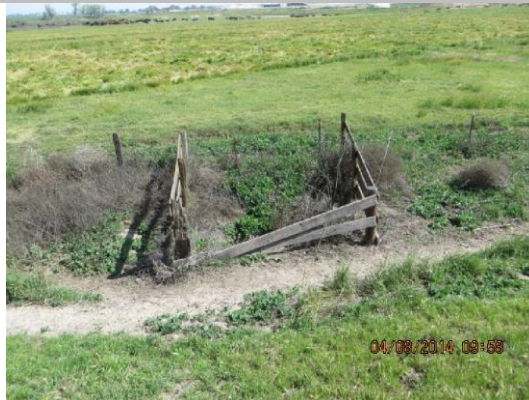
Photo 3 of 3 : UCIP_SP_2017_39100_60671.jpg

Wooded barrier around drop-inlet on LS toe.

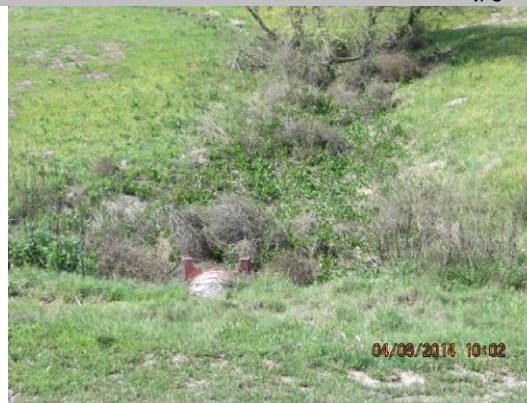
Photo 1 of 3 : UCIP_SP_2017_39123_60675.jpg

FS_ID:39123
DS_ID:19570
EP_NO: N/A
Repair Type: Non-Urgent
Crossing Status: Found
UCIP Comments: Unable to find inlet on landward toe. Recommend clearing vegetation on landward side to properly inspect inlet.
FIELD_STRUCT_DESC: 24-inch CM stormdrain pipe through the levee, 9.8 feet below the crown. Flap gate on waterward end. Brass cap No. 100 BM on headwall on the landward side. (USACE-1967). This entry matches the Drainage or Irrigation Structure referenced in O&M manual (HLM 2.08).
FS Date: 4/8/2014

Pipe and flapgate visible on WS toe.

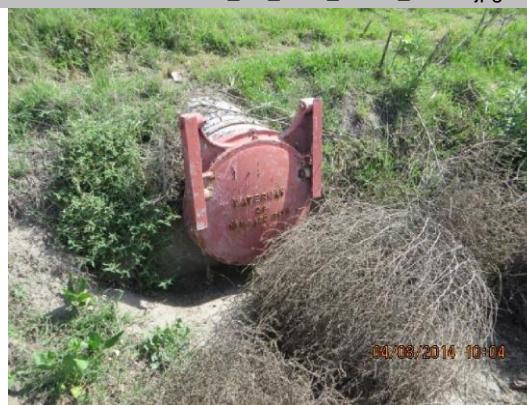
Photo 2 of 3 : UCIP_SP_2017_39123_60676.jpg

Pipe and flapgate visible on WS toe.

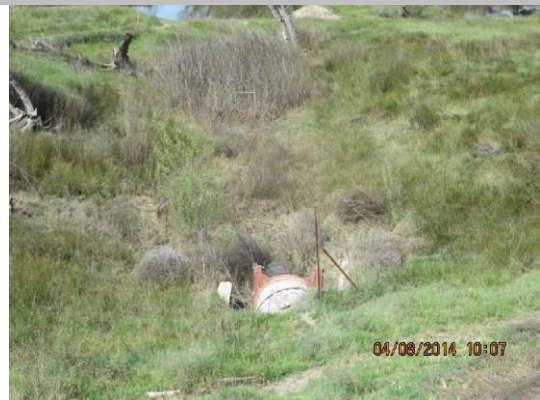
Photo 1 of 3 : UCIP_SP_2017_39125_71309.jpg

Pipe and flapgate on WS toe.

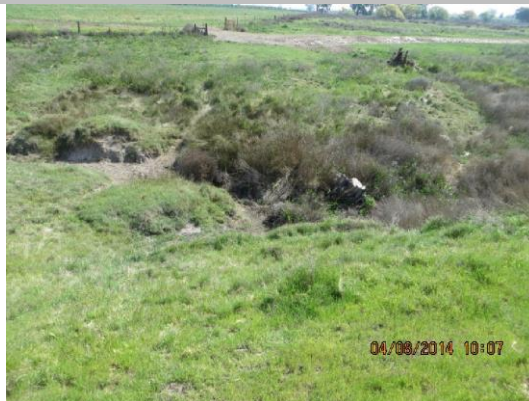
Photo 2 of 3 : UCIP_SP_2017_39125_71308.jpg

Pipe and headwall on LS toe.

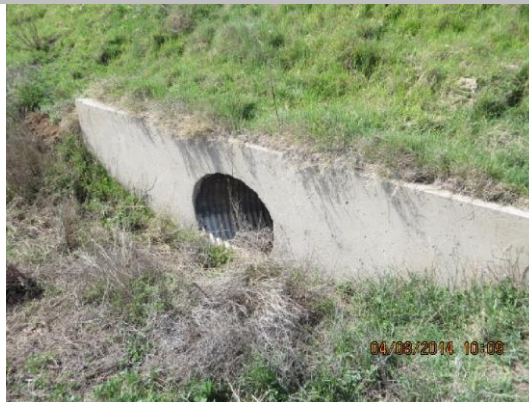
Photo 3 of 3 : UCIP_SP_2017_39125_71307.jpg

Pipe and headwall on LS toe.

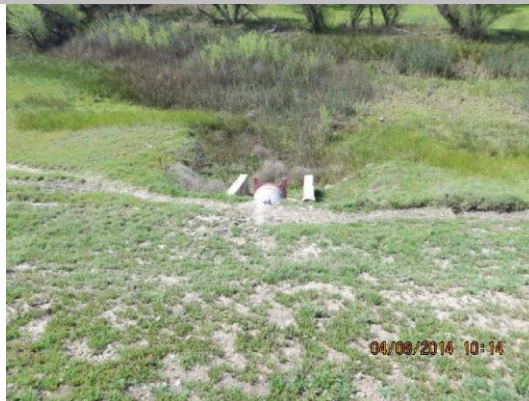
Photo 1 of 3 : UCIP_SP_2017_33568_60679.jpg

Pipe, headwall, and flapgate on WS toe.

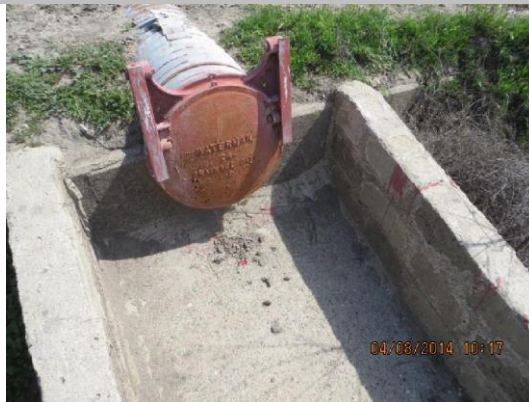
Photo 2 of 3 : UCIP_SP_2017_33568_60680.jpg

Pipe, headwall, and flapgate on WS toe.

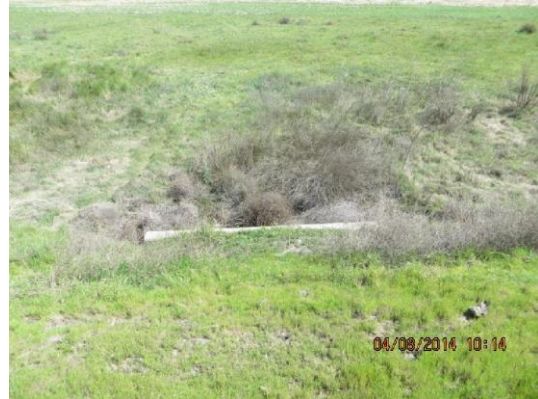
Photo 3 of 3 : UCIP_SP_2017_33568_60678.jpg

Pipe and headwall on LS toe.

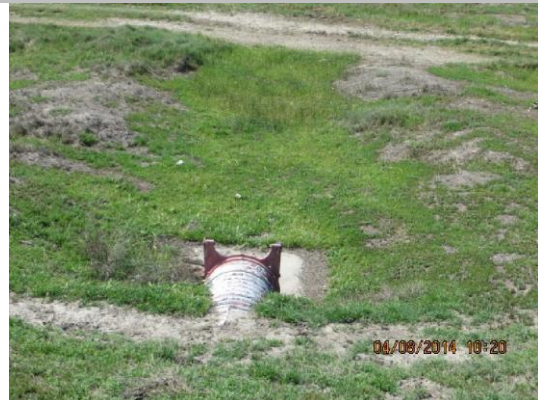
Photo 1 of 3 : UCIP_SP_2017_39127_60688.jpg

LM Start	2.67	Rating **	M	Issue No.	1199
LM End	2.67	Issue Type +	Ma	Location *	LS
Category	Supplemental			GPS Latitude/Longitude	
				Start	End
Item	DWR UCIP LMA Responsibility			37.327362 °	37.327362 °
				-120.931591 °	-120.931591 °
DWR ID					
Comment Code					
Inspector Comment					
FS_ID:39127					
DS_ID:19573					
EP_NO: N/A					
Repair Type: Non-Urgent					
Crossing Status: Found					
UCIP Comments: Sedimentation in pipe at landward toe.					
FIELD_STRUCT_DESC: 24-inch CM stormdrain pipe through the levee, 7.3 feet below the crown. Flap gate on the waterward end. Brass cap No. 100 BM on headwall on the landward side. (USACE-1967). This entry matches the Drainage or Irrigation Structure referenced in O&M manual (HLM 2.70).					
FS Date: 4/8/2014

Pipe, flapgate, and headwall on WS toe.

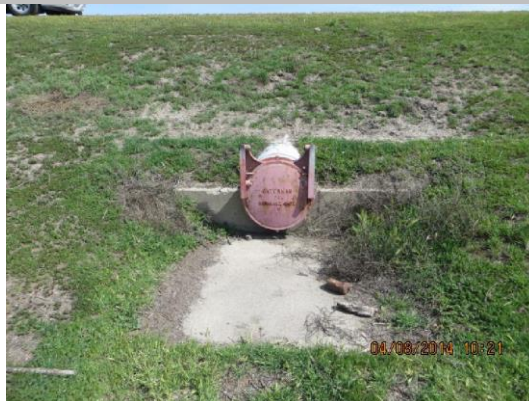
Photo 2 of 3 : UCIP_SP_2017_39127_60689.jpg

Pipe, flapgate, and headwall on WS toe.

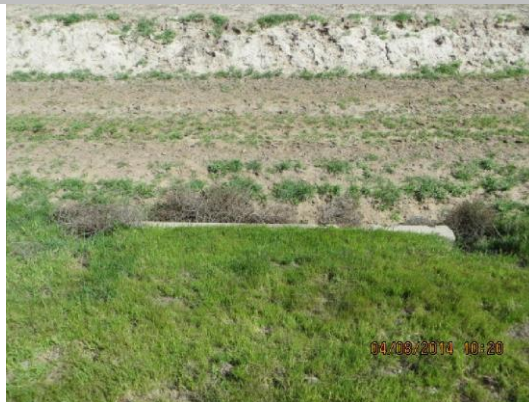
Photo 3 of 3 : UCIP_SP_2017_39127_60687.jpg

Pipe and headwall on LS toe.

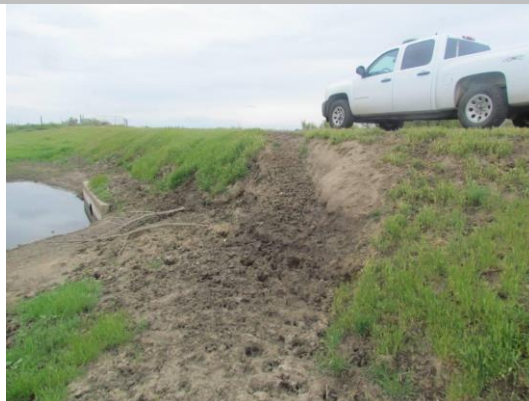
Photo 1 of 1 : SP_2017_NA0010_118_108_20170424_00271.jpg

LM Start	3.13	Rating **	M	Issue No.	108
LM End	3.13	Issue Type +	Ma	Location *	LS
Category	Earthen Levee			GPS Latitude/Longitude	
				Start	End
Item	Slope Stability			37.321468 °	37.321468 °
				-120.928757 °	-120.928757 °
DWR ID	DWR_NA0010_01_s_2017_108				
Comment Code					
S2 : Repair the levee slope damaged by foot traffic and prevent access where possible.					
Inspector Comment					
Slope damage caused by animal traffic on landward toe.

Looking west at slope damage caused by animal traffic.

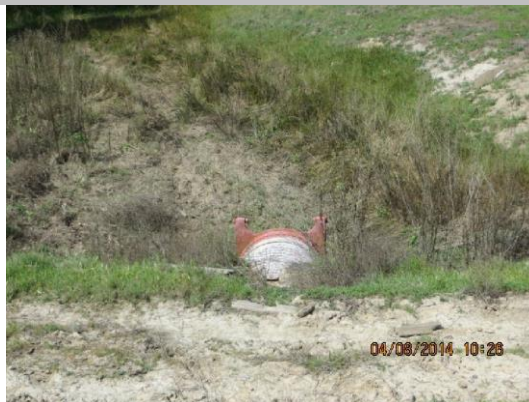
Photo 1 of 3 : UCIP_SP_2017_39128_60702.jpg

LM Start	3.13	Rating **	M	Issue No.	1200
LM End	3.13	Issue Type +	Ma	Location *	LS
Category	Supplemental			GPS Latitude/Longitude	
				Start	End
Item	DWR UCIP LMA Responsibility			37.321444 °	37.321444 °
				-120.928764 °	-120.928764 °
DWR ID					
Comment Code					
Inspector Comment					
FS_ID:39128					
DS_ID:19574					
EP_NO: N/A					
Repair Type: Non-Urgent					
Crossing Status: Found					
UCIP Comments: Some minor erosion around headwall on LS toe.					
FIELD_STRUCT_DESC: 36-inch CM pipe through the levee, 8-feet below the crown. Flap gate on the waterward end. Brass cap No. 100					
BM on headwall on the landward side. (USACE-1967). This entry matches the Drainage or Irrigation Structure referenced in O&M manual (HLM 3.16).					
FS Date: 4/8/2014

Pipe, Flapgate, and headwall on WS toe.

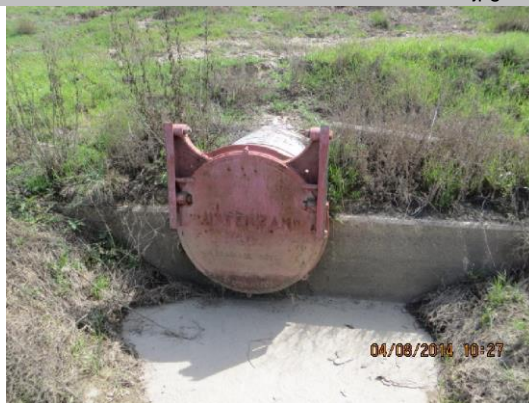
Photo 2 of 3 : UCIP_SP_2017_39128_60700.jpg

Pipe, Flapgate, and headwall on WS toe.

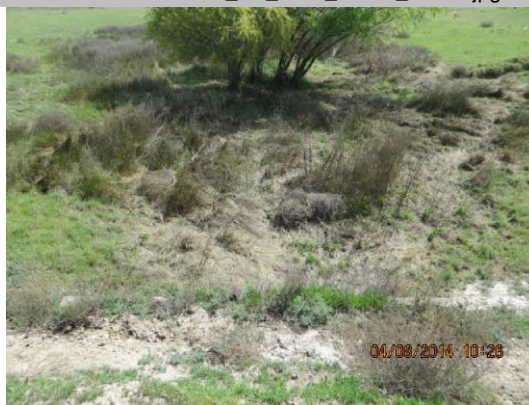
Photo 3 of 3 : UCIP_SP_2017_39128_60701.jpg

Pipe and headwall on LS toe.

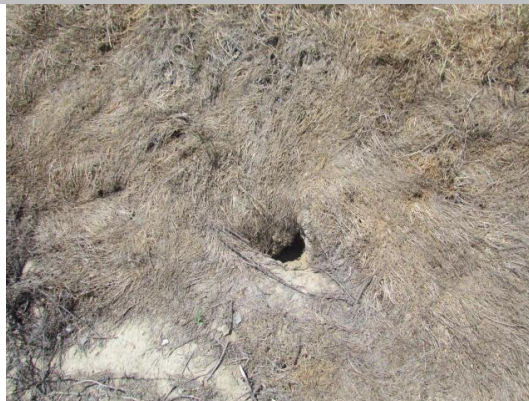
Photo 1 of 2 : SP_2017_NA0010_118_10_20170417_00008.jpg

LM Start	3.16	Rating **	M	Issue No.	10
LM End	3.16	Issue Type +	Ma	Location *	LS
Category	Earthen Levee			GPS Latitude/Longitude	
				Start	End
Item	Animal Control			37.321053 °	37.321053 °
				-120.928785 °	-120.928785 °
DWR ID	DWR_NA0010_01_s_2012_10				
Comment Code					
A3 : No rodents visible, but rodent burrows visible; need to backfill and compact or grout burrows.					
Inspector Comment					
Several rodent holes noted within this section. Rodent hole noted on waterward shoulder next to fence pole.

Looking at typical view of rodent holes on landward slope.

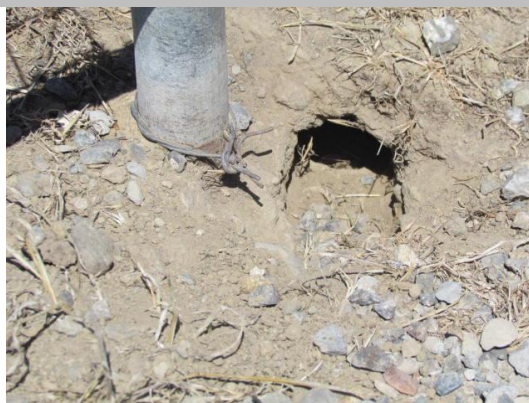
Photo 2 of 2 : SP_2017_NA0010_118_10_20170417_00009.jpg

Looking at rodent hole next to fence pole on landward shoulder.

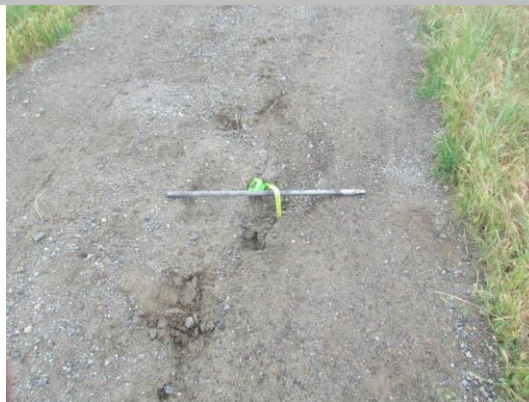
Photo 1 of 4 : SP_2017_NA0010_118_109_20170424_00272.jpg

LM Start	3.26	Rating **	U	Issue No.	109
LM End	3.29	Issue Type +	Ma	Location *	CR
Category	Earthen Levee			GPS Latitude/Longitude	
				Start	End
Item	Crown Surface / Depressions / Rutting			37.319740 °	37.319300 °
				-120.928308 °	-120.927903 °
DWR ID	DWR_NA0010_01_s_2017_109				
Comment Code					
C2 : Repair depressions or ruts in the crown or slope.					
Inspector Comment					
Depression (sinkhole) on levee crown and other depressions

Looking south at sinkhole on levee crown

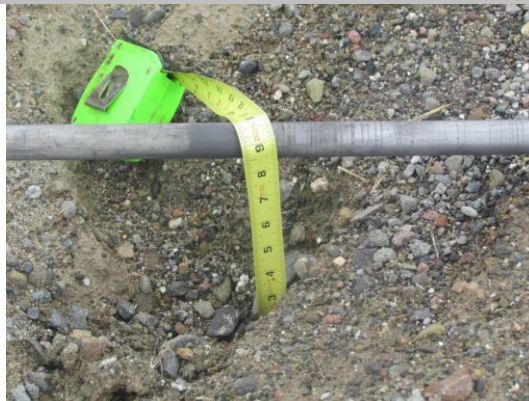
Photo 2 of 4 : SP_2017_NA0010_118_109_20170424_00273.jpg

Looking south at close view of sinkhole on levee crown

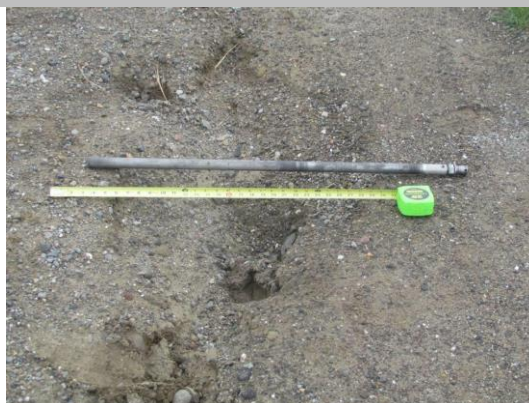
Photo 3 of 4 : SP_2017_NA0010_118_109_20170424_00274.jpg

Looking south at sinkhole on levee crown.

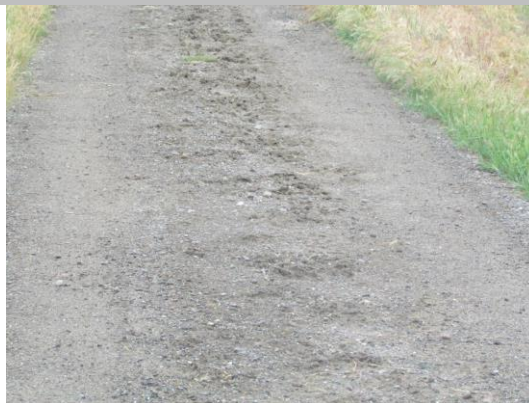
Photo 4 of 4 : SP_2017_NA0010_118_109_20170424_00275.jpg

Looking south at rutting on levee crown.

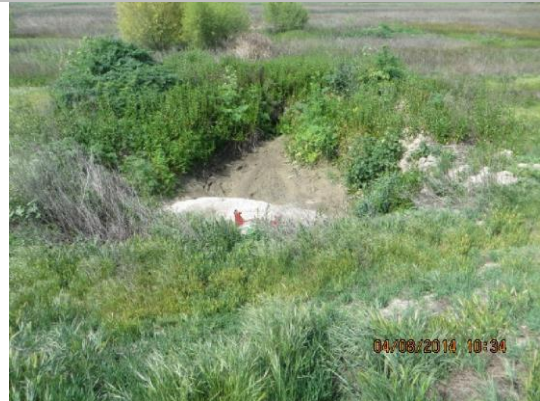
Photo 1 of 3 : UCIP_SP_2017_50054_60707.jpg

FS_ID:50054
DS_ID:19575
EP_NO: N/A
Repair Type: Urgent
Crossing Status: Found
UCIP Comments: 7/19/2016 Same as previous inspection. Erosion present on LS slope. (DWR UCIP - omagana)4/08/2014 Pipe rusted through at Springline on LS toe. Flapgate blocked by sediment on WS toe. Heavy sediment on both ends of pipe. Need to contact owner to address issues. (DWR UCIP - omagana)
FIELD_STRUCT_DESC: 36-inch corrugated metal drainage pipe through the levee, 9.7 feet below the crown. Flap gate located on the waterside (WS) end. Brass cap No. 100 BM on headwall located on the landside (LS). [Additional Reference(s): DWR Levee Log, 2002. USACE San Joaquin O&M Manuals: Unit No. 601, 1967, (HLM 3.50), Unit No. 601 Part I, 1967 (Amended in 1978), Unit No. 601 Part II, 1969, and Unit No. 601 Part III, 1969].
FS Date: 7/19/2016

Pipe, headwall, and flapgate on WS toe.

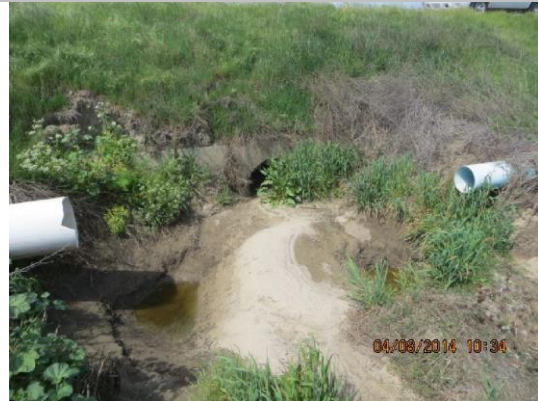
Photo 3 of 3 : UCIP_SP_2017_50054_60705.jpg

Comment Code					
Inspector Comment					
FS_ID:50054 DS_ID:19575 EP_NO: N/A Repair Type: Urgent Crossing Status: Found UCIP Comments: 7/19/2016 Same as previous inspection. Erosion present on LS slope. (DWR UCIP - omagana)4/08/2014 Pipe rusted through at Springline on LS toe. Flapgate blocked by sediment on WS toe. Heavy sediment on both ends of pipe. Need to contact owner to address issues. (DWR UCIP - omagana) FIELD_STRUCT_DESC: 36-inch corrugated metal drainage pipe through the levee, 9.7 feet below the crown. Flap gate located on the waterside (WS) end. Brass cap No. 100 BM on headwall located on the landside (LS). [Additional Reference(s): DWR Levee Log, 2002. USACE San Joaquin O&M Manuals: Unit No. 601, 1967, (HLM 3.50), Unit No. 601 Part I, 1967 (Amended in 1978), Unit No. 601 Part II, 1969, and Unit No. 601 Part III, 1969]. FS Date: 7/19/2016

Pipe and headwall on LS toe.

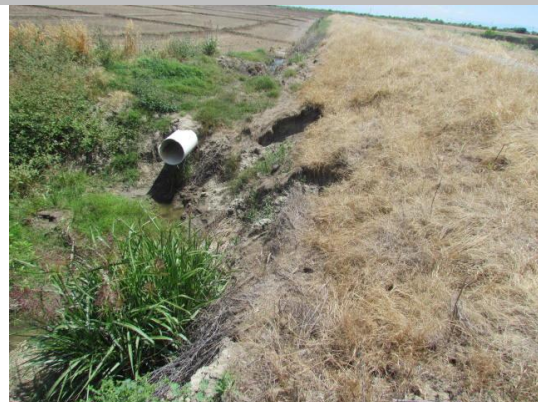
Photo 1 of 3 : SP_2017_NA0010_118_1179_20170417_00029.jpg

LM Start	3.47	Rating **	U	Issue No.	1179
LM End	3.47	Issue Type +	Ma	Location *	LS
Category	Earthen Levee			GPS Latitude/Longitude	
				Start	End
Item	Erosion / Bank Caving			37.317057 °	37.317057 °
				-120.926443 °	-120.926443 °
DWR ID	DWR_NA0010_01_s_2015_1179				
Comment Code					
E2 : Schedule repair of erosion site prior to the next inspection.					
Inspector Comment					
Several erosions greater than three inches on landward slope.

Looking south at erosion on landward slope and toe.

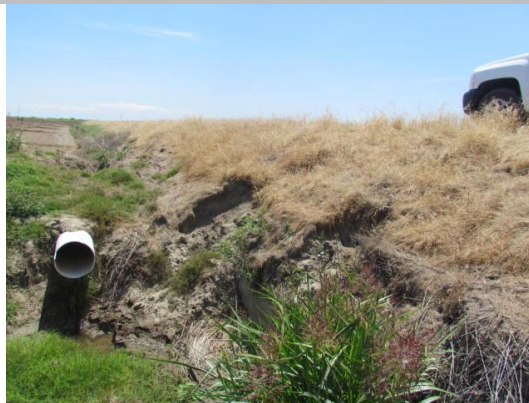
Photo 2 of 3 : SP_2017_NA0010_118_1179_20170417_00030.jpg

LM Start	3.47	Rating **	U	Issue No.	1179 (cont)	
LM End	3.47	Issue Type +	Ma	Location *	LS	
Category	Earthen Levee			GPS Latitude/Longitude		
				Start		End
Item	Erosion / Bank Caving			37.317057 °		37.317057 °
				-120.926443 °		-120.926443 °
DWR ID	DWR_NA0010_01_s_2015_1179					
Comment Code						
E2 : Schedule repair of erosion site prior to the next inspection.						
Inspector Comment						
Several erosions greater than three inches on landward slope.

Looking southwest at erosion on landward slope and toe.

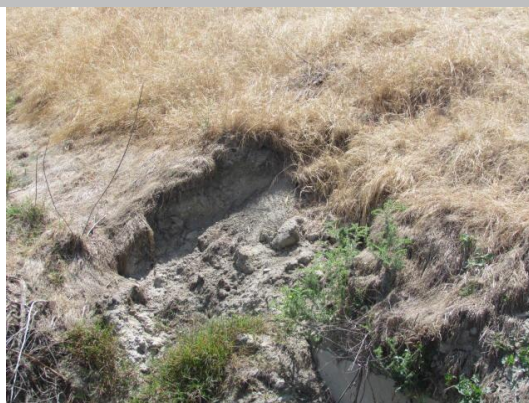
Photo 3 of 3 : SP_2017_NA0010_118_1179_20170417_00031.jpg

Looking west at erosion on landward slope and toe.

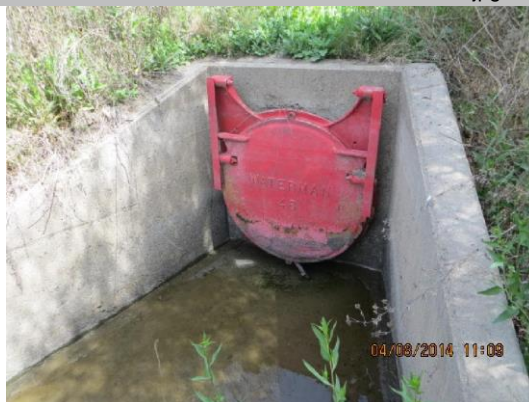
Photo 1 of 3 : UCIP_SP_2017_39134_60730.jpg

FS_ID:39134
DS_ID:19607
EP_NO: N/A
Repair Type: Non-Urgent
Crossing Status: Found
UCIP Comments: Pipe appears sleeved with a 12-inch steel pipe with a slide gate at the LS toe. No identified authorization for changes to this crossing. Need to contact owner to obtain additional information about the modifications to crossing.
FIELD_STRUCT_DESC: 48-inch CM stormdrain pipe through the levee, 14.0 feet below the crown. Flap gate on the waterward end. Brass cap No. 90 BM on headwall on the landward side. (USACE-1967). This entry matches the Drainage or Irrigation Structure referenced in O&M manual (HLM 4.16).
FS Date: 4/8/2014

Concrete headwall and 48-inch flapgate visible on WS toe.

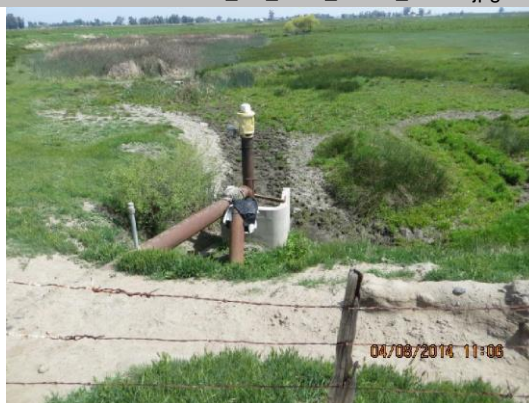
Photo 2 of 3 : UCIP_SP_2017_39134_60731.jpg

Assumed pipe exists under pump at LS toe.

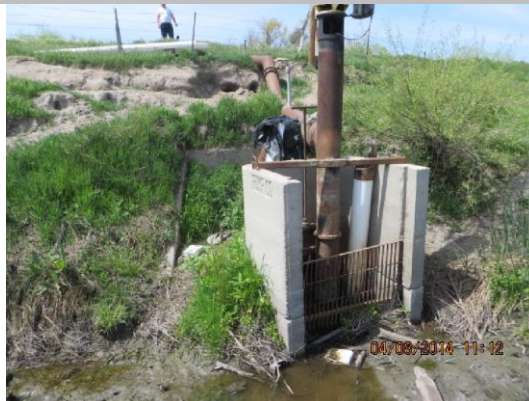
Photo 3 of 3 : UCIP_SP_2017_39134_60729.jpg

Item	DWR UCIP LMA Responsibility			37.309080 °	37.309080 °	
				-120.924442 °	-120.924442 °	
DWR ID						
Comment Code						
Inspector Comment						
FS_ID:39134 DS_ID:19607 EP_NO: N/A Repair Type: Non-Urgent Crossing Status: Found UCIP Comments: Pipe appears sleeved with a 12-inch steel pipe with a slide gate at the LS toe. No identified authorization for changes to this crossing. Need to contact owner to obtain additional information about the modifications to crossing. FIELD_STRUCT_DESC: 48-inch CM stormdrain pipe through the levee, 14.0 feet below the crown. Flap gate on the waterward end. Brass cap No. 90 BM on headwall on the landward side. (USACE-1967). This entry matches the Drainage or Irrigation Structure referenced in O&M manual (HLM 4.16). FS Date: 4/8/2014

Concrete inlet, slidegate, and concrete headwall at LS toe.

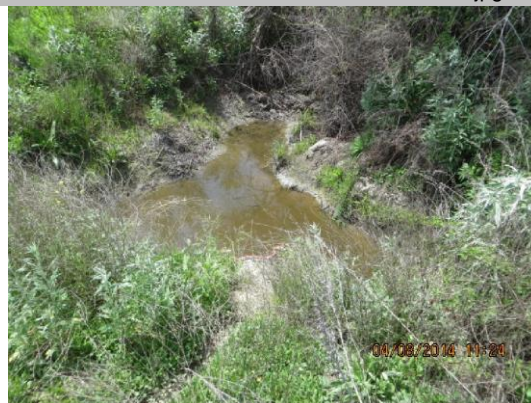
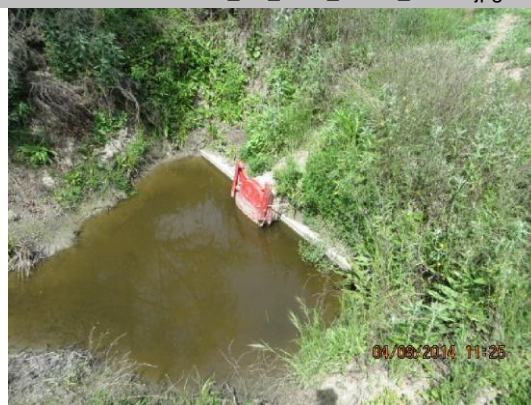
FS_ID:39140
DS_ID:19608
EP_NO: N/A
Repair Type: Non-Urgent
Crossing Status: Found
UCIP Comments: Dense vegetation and fence limits the inspector's visibility to identify signs of pipe failure (leaks) along the landward side. Recommend obtaining access to landward toe and removing vegetation along pipe alignment to conduct proper inspection of structure and appurtenances.
FIELD_STRUCT_DESC: 24-inch CM stormdrain pipe through the levee, 11.9 feet below the crown. Flap gate on the waterward end. Brass cap No. 90 BM on headwall on the landward side. (USACE-1967). This entry matches the Drainage or Irrigation Structure referenced in O&M manual (HLM 4.27).
FS Date: 4/8/2014

Pipe, flapgate, and headwall visible at WS toe.

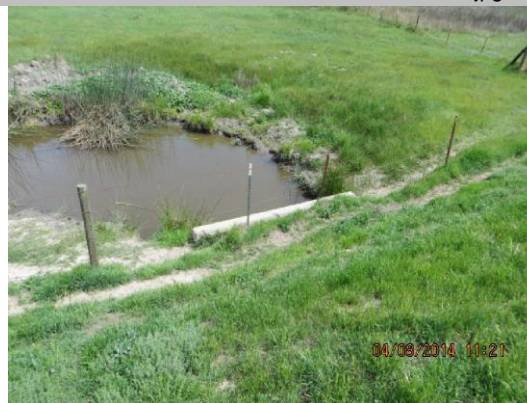
Photo 3 of 3 : UCIP_SP_2017_39140_60734.jpg

Comment Code					
Inspector Comment					
FS_ID:39140					
DS_ID:19608					
EP_NO: N/A					
Repair Type: Non-Urgent					
Crossing Status: Found					
UCIP Comments: Dense vegetation and fence limits the inspector's visibility to identify signs of pipe failure (leaks) along the landward side. Recommend obtaining access to landward toe and removing vegetation along pipe alignment to conduct proper inspection of structure and appurtenances.					
FIELD_STRUCT_DESC: 24-inch CM stormdrain pipe through the levee, 11.9 feet below the crown. Flap gate on the waterward end. Brass cap No. 90 BM on headwall on the landward side. (USACE-1967). This entry matches the Drainage or Irrigation Structure referenced in O&M manual (HLM 4.27).					
FS Date: 4/8/2014

Concrete headwall at LS toe.

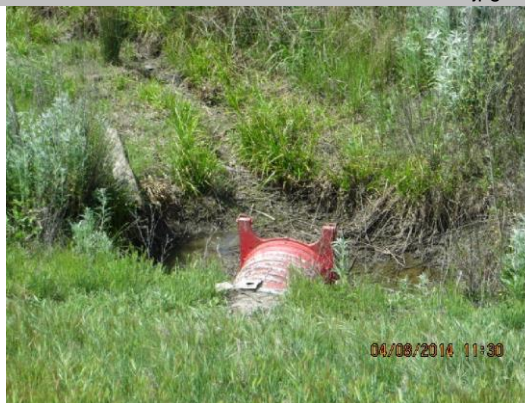
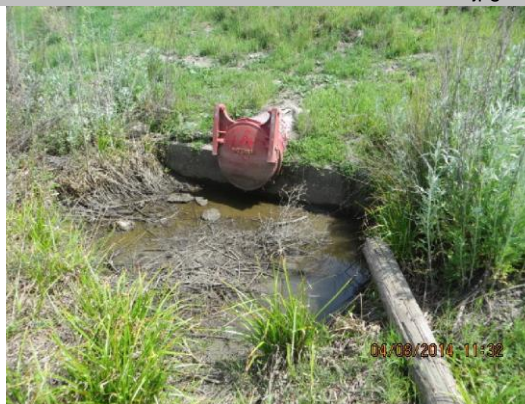
FS_ID:39141
DS_ID:19609
EP_NO: N/A
Repair Type: Non-Urgent
Crossing Status: Found
UCIP Comments: Dense vegetation limits the inspector's visibility to identify signs of pipe failure (leaks) along the waterward side. Recommend removing vegetation along pipe alignment to conduct proper inspection of structure and appurtenances.
FIELD_STRUCT_DESC: 24-inch CM stormdrain pipe through the levee, 10.0-feet below the crown. Flap gate on the waterward end. Brass cap No. 90 BM on headwall on the landward side. (USACE-1967). This entry matches the Drainage or Irrigation Structure referenced in O&M manual (HLM 4.72).
FS Date: 4/8/2014

Pipe, flapgate, and headwall on WS toe.

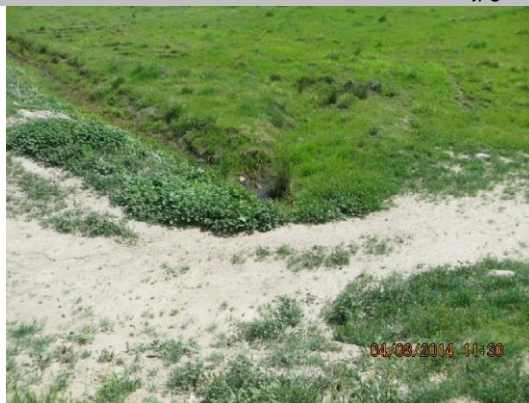
Photo 3 of 3 : UCIP_SP_2017_39141_60736.jpg

Item	DWR UCIP LMA Responsibility			37.302408 °	37.302408 °	
				-120.920931 °	-120.920931 °	
DWR ID						
Comment Code						
Inspector Comment						
FS_ID:39141 DS_ID:19609 EP_NO: N/A Repair Type: Non-Urgent Crossing Status: Found UCIP Comments: Dense vegetation limits the inspector's visibility to identify signs of pipe failure (leaks) along the waterward side. Recommend removing vegetation along pipe alignment to conduct proper inspection of structure and appurtenances. FIELD_STRUCT_DESC: 24-inch CM stormdrain pipe through the levee, 10.0-feet below the crown. Flap gate on the waterward end. Brass cap No. 90 BM on headwall on the landward side. (USACE-1967). This entry matches the Drainage or Irrigation Structure referenced in O&M manual (HLM 4.72). FS Date: 4/8/2014

Pipe and concrete headwall on LS toe.

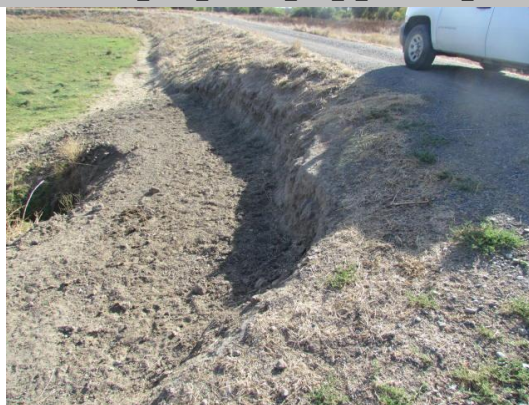
Photo 1 of 1 : SP_2017_NA0010_118_9_20170417_00007.jpg

LM Start	4.69	Rating **	U	Issue No.	9
LM End	4.69	Issue Type +	Ma	Location *	LS
Category	Earthen Levee			GPS Latitude/Longitude	
				Start	End
Item	Animal Control			37.302398 °	37.302398 °
				-120.920920 °	-120.920920 °
DWR ID	DWR_NA0010_01_s_2013_9				
Comment Code					
A2 : Repair the levee slope damaged by livestock and prevent large animal access.					
Inspector Comment					
Levee landward toe damaged by livestock.

Looking at landward slope damaged by livestock.

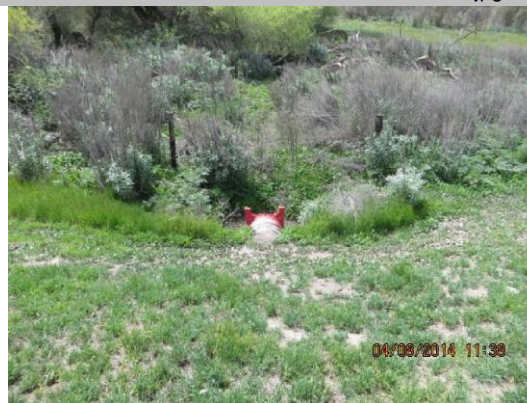
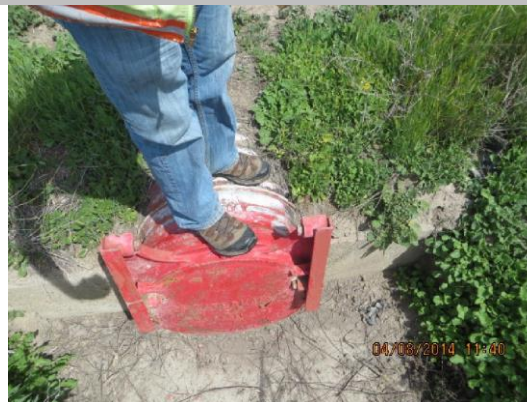
FS_ID:39143
DS_ID:19610
EP_NO: N/A
Repair Type: Non-Urgent
Crossing Status: Found
UCIP Comments: Non-functional -- sediment buildup against flapgate and inlet buried at landward side.
FIELD_STRUCT_DESC: 24-inch CM stormdrain pipe through the levee, 8.0 feet below the crown. Flap gate on the waterward end. Brass cap No. 90 BM on headwall on the landward side. (USACE-1967). This entry matches the Drainage or Irrigation Structure referenced in O&M manual (HLM 5.05).
FS Date: 4/8/2014

Flapgate and headwall visible at WS toe.

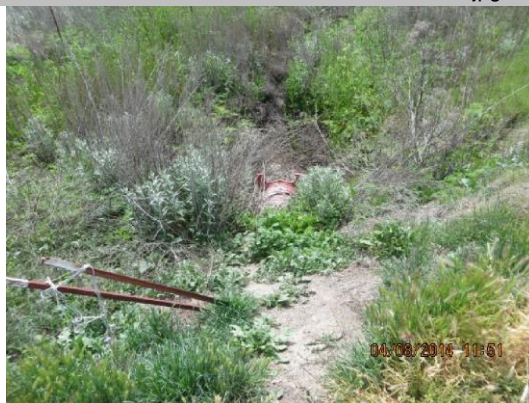
Photo 1 of 2 : UCIP_SP_2017_39151_60742.jpg

FS_ID:39151
DS_ID:19611
EP_NO: N/A
Repair Type: Non-Urgent
Crossing Status: Found
UCIP Comments: Dense vegetation limits the inspector's visibility to identify signs of pipe failure (leaks) along waterward and landward slopes. Recommend removing vegetation along pipe alignment to conduct proper inspection of structure and appurtenances. Landward side filled in with soil. Need to contact owner. If crossing is no longer used need to coordinate with CVFPB for proper abandonment.
FIELD_STRUCT_DESC: 24-inch CM stormdrain pipe through the levee, 8.6 feet below the crown. Flap gate on the waterward end. Brass cap No. 90 BM on headwall on the landward side. (USACE-1967). This entry matches the Drainage or Irrigation Structure referenced in O&M manual (HLM 5.95).
FS Date: 4/8/2014

Pipe, concrete headwall, and flapgate visible on WS toe.

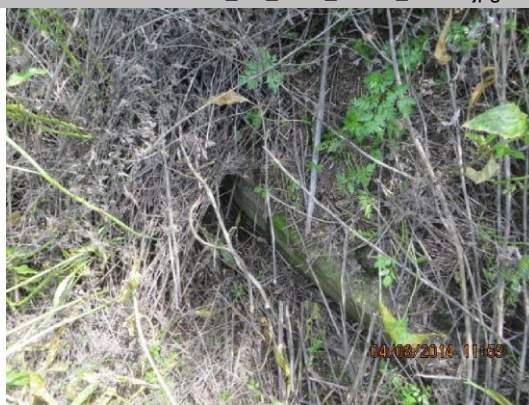
Photo 2 of 2 : UCIP_SP_2017_39151_60741.jpg

Top of concrete headwall just visible on LS toe.
