**Flood Control Project Maintenance
Levee Inspections**

Maintenance Issue Types Only, Levee Inspection Report By Mile - Spring 2017

Lower San Joaquin Levee District

Waterway	Bank	Unit Miles	Inspection Start/End	Inspector
Unit No. 01 San Joaquin River	Right	22.52	04/17/2017 04/20/2017	Richard Willoughby

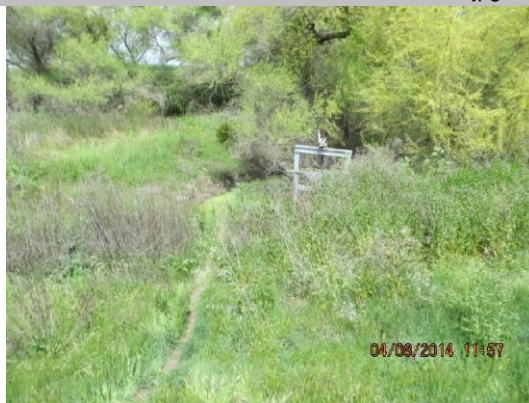
Photo 1 of 3 : UCIP_SP_2017_39152_60745.jpg

FS_ID:39152
DS_ID:19612
EP_NO: N/A
Repair Type: Non-Urgent
Crossing Status: Found
UCIP Comments: Dense vegetation limits the inspector's visibility to identify signs of pipe failure (leaks) along waterward and landward slopes. Recommend removing vegetation along pipe alignment to conduct proper inspection of structure and appurtenances. Pipe completely blocked by soil on LS toe due to animal activity. Slide gate blocked open.
FIELD_STRUCT_DESC: 48-inch CM pipe through the levee, 13.1 feet below the crown. Walkway to slidegate on LS toe at concrete headwall. Flap gate at concrete headwall on the WS toe. Brass cap No. 90 BM on headwall on the landward side. (USACE-1967). Pipe crosses levee at an angle to levee alignment. This entry matches the Drainage or Irrigation Structure referenced in O&M manual (HLM 6.13).
FS Date: 4/8/2014

Slidegate at LS toe.

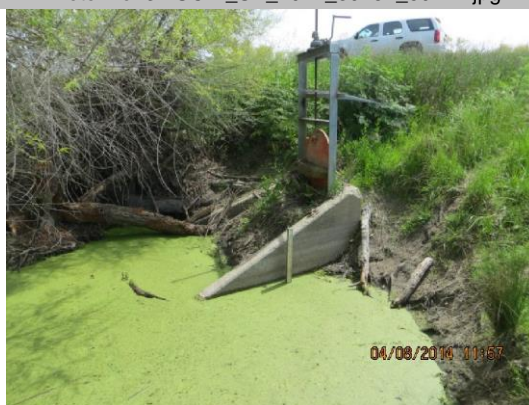
Photo 2 of 3 : UCIP_SP_2017_39152_60744.jpg

Pipe, concrete headwall, slidegate, and metal walkway on LS toe.

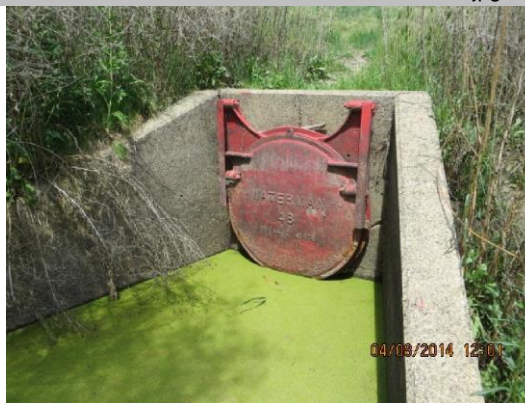
Photo 3 of 3 : UCIP_SP_2017_39152_60743.jpg

FS_ID:39152
DS_ID:19612
EP_NO: N/A
Repair Type: Non-Urgent
Crossing Status: Found
UCIP Comments: Dense vegetation limits the inspector's visibility to identify signs of pipe failure (leaks) along waterward and landward slopes. Recommend removing vegetation along pipe alignment to conduct proper inspection of structure and appurtenances. Pipe completely blocked by soil on LS toe due to animal activity. Slide gate blocked open.
FIELD_STRUCT_DESC: 48-inch CM pipe through the levee, 13.1 feet below the crown. Walkway to slidegate on LS toe at concrete headwall. Flap gate at concrete headwall on the WS toe. Brass cap No. 90 BM on headwall on the landward side. (USACE-1967). Pipe crosses levee at an angle to levee alignment. This entry matches the Drainage or Irrigation Structure referenced in O&M manual (HLM 6.13).
FS Date: 4/8/2014

Flapgate on concrete headwall at WS toe.

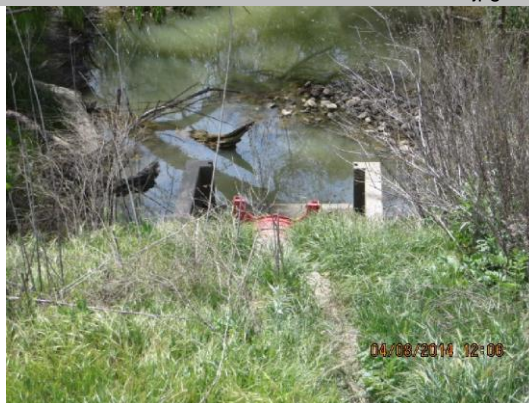
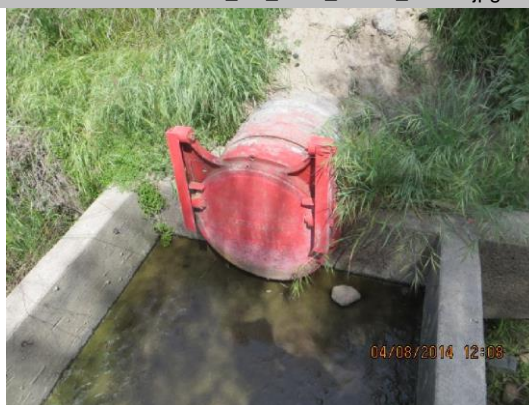
FS_ID:39154
DS_ID:19613
EP_NO: N/A
Repair Type: Non-Urgent
Crossing Status: Found
UCIP Comments: Dense vegetation limits the inspector's visibility to identify signs of pipe failure (leaks) along the slope. Recommend removing vegetation along pipe alignment to conduct proper inspection of structure and appurtenances.
FIELD_STRUCT_DESC: 24-inch CM stormdrain pipe through the levee, 9.5 feet below the crown. Flap gate on the waterward end. Slide gate on the landward end next to 48-inch concrete riser with walkway over its top. Brass cap No. 90 BM on headwall on the landward side. (USACE-1967). This entry matches the Drainage or Irrigation Structure referenced in O&M manual (HLM 6.40).
FS Date: 4/8/2014

Pipe, flapgate, and concrete headwall on WS toe.

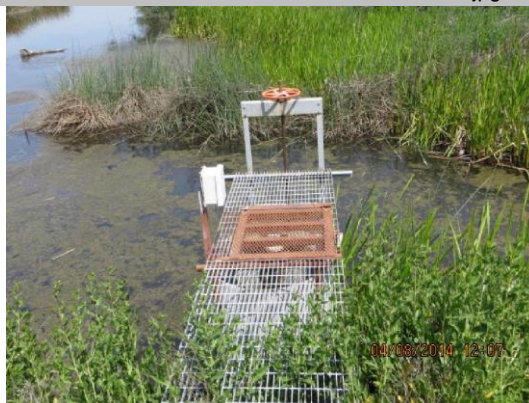
Photo 3 of 3 : UCIP_SP_2017_39154_60761.jpg

Comment Code					
Inspector Comment					
FS_ID:39154 DS_ID:19613 EP_NO: N/A Repair Type: Non-Urgent Crossing Status: Found UCIP Comments: Dense vegetation limits the inspector's visibility to identify signs of pipe failure (leaks) along the slope. Recommend removing vegetation along pipe alignment to conduct proper inspection of structure and appurtenances. FIELD_STRUCT_DESC: 24-inch CM stormdrain pipe through the levee, 9.5 feet below the crown. Flap gate on the waterward end. Slide gate on the landward end next to 48-inch concrete riser with walkway over its top. Brass cap No. 90 BM on headwall on the landward side. (USACE-1967). This entry matches the Drainage or Irrigation Structure referenced in O&M manual (HLM 6.40). FS Date: 4/8/2014

Metal walkway over concrete standpipe next to slide gate on LS toe.

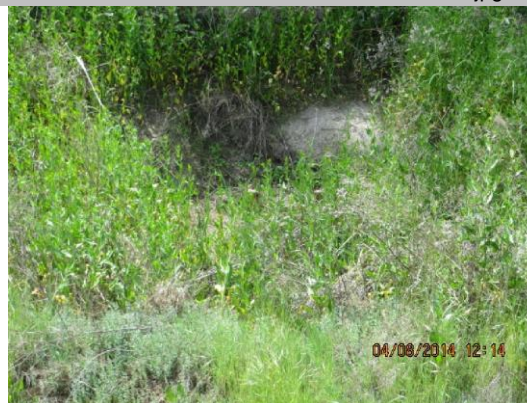
Photo 1 of 3 : UCIP_SP_2017_49962_60764.jpg

FS_ID:49962
DS_ID:19614
EP_NO: N/A
Repair Type: Non-Urgent
Crossing Status: Found
UCIP Comments: 7/19/2016 Same as previous inspection. Outlet and inlet are under water. (DWR UCIP - omagana)4/08/2014 Flapgate blocked by sedimentation at WS toe. Dense vegetation limits the inspector's visibility to identify signs of pipe failure (leaks) along the slope. Recommend removing vegetation along pipe alignment to conduct proper inspection of structure and appurtenances. Also recommend clearing vegetation from both waterward and landward toe. (DWR UCIP - omagana)
FIELD_STRUCT_DESC: 24-inch corrugated metal drainage pipe through the levee, 9.8 feet below the crown. Wooden fence around 4-foot by 4-foot drop inlet located on the landside (LS) toe. Flap gate located on the waterside (WS) end. Brass cap No. 90 BM on headwall located on the LS. [Additional Reference(s): DWR Levee Log, 2002. USACE San Joaquin O&M Manuals: Unit No. 601, 1967, (HLM 6.64), Unit No. 601 Part I, 1967 (Amended in 1978), Unit No. 601 Part II, 1969, and Unit No. 601 Part III, 1969]

Pipe and flapgate visible on WS toe.

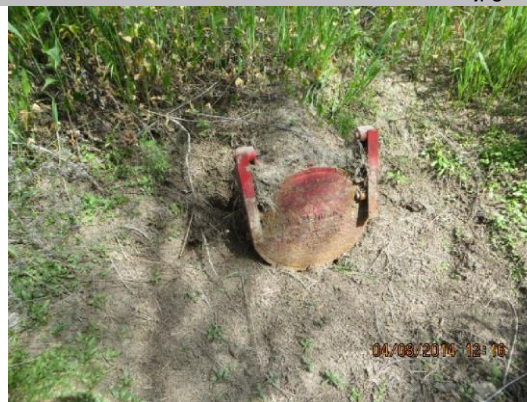
Photo 2 of 3 : UCIP_SP_2017_49962_60766.jpg

Pipe and flapgate visible at WS toe. Flapgate blocked by sedimentation on WS toe.

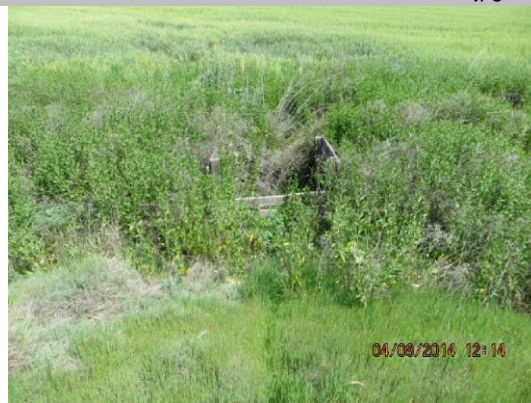
Photo 3 of 3 : UCIP_SP_2017_49962_60765.jpg

FS_ID:49962
DS_ID:19614
EP_NO: N/A
Repair Type: Non-Urgent
Crossing Status: Found
UCIP Comments: 7/19/2016 Same as previous inspection. Outlet and inlet are under water. (DWR UCIP - omagana)4/08/2014 Flapgate blocked by sedimentation at WS toe. Dense vegetation limits the inspector's visibility to identify signs of pipe failure (leaks) along the slope. Recommend removing vegetation along pipe alignment to conduct proper inspection of structure and appurtenances. Also recommend clearing vegetation from both waterward and landward toe. (DWR UCIP - omagana)
FIELD_STRUCT_DESC: 24-inch corrugated metal drainage pipe through the levee, 9.8 feet below the crown. Wooden fence around 4-foot by 4-foot drop inlet located on the landside (LS) toe. Flap gate located on the waterside (WS) end. Brass cap No. 90 BM on headwall located on the LS. [Additional Reference(s): DWR Levee Log, 2002. USACE San Joaquin O&M Manuals: Unit No. 601, 1967, (HLM 6.64), Unit No. 601 Part I, 1967 (Amended in 1978), Unit No. 601 Part II, 1969, and Unit No. 601 Part III, 1969]

Wooden barrier around drop inlet on LS toe. Excess vegetation.

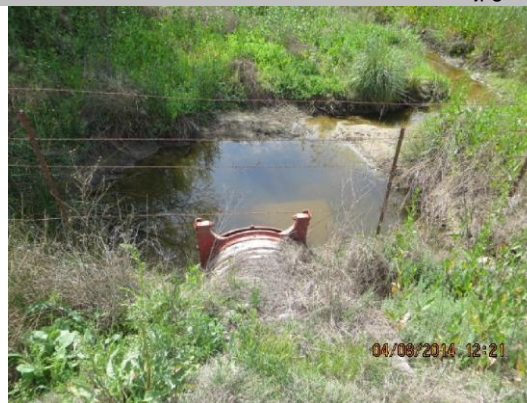
Photo 1 of 3 : UCIP_SP_2017_50077_60768.jpg

FS_ID:50077
DS_ID:19615
EP_NO: N/A
Repair Type: Non-Urgent
Crossing Status: Found
UCIP Comments: 7/19/2016 Potential LS slope damage--difficult to determine due to dense vegetation. Limited access on WS toe due to wire fence. (DWR UCIP - omagana)4/08/2014 Slide gate blocked by debris at LS toe. Flapgate won't close because of debris. Dense vegetation limits the inspector's visibility to identify signs of pipe failure (leaks) along the slope. Recommend removing vegetation along pipe alignment to conduct proper inspection of structure and appurtenances. (DWR UCIP - omagana)
FIELD_STRUCT_DESC: 36-inch corrugated metal drainage pipe through the levee, 10.3 feet below the crown. Slidegate located on landside (LS) toe and a flap gate located on the waterside (WS) end. Brass cap No. 90 BM is located on headwall on the LS. [Additional Reference(s): DWR Levee Log, 2002. USACE San Joaquin O&M Manuals: Unit No. 601, 1967, (HLM 6.90), Unit No. 601 Part I, 1967 (Amended in 1978), Unit No. 601 Part II, 1969, and Unit No. 601 Part III, 1969]

Pipe, headwall, and flapgate on WS toe.

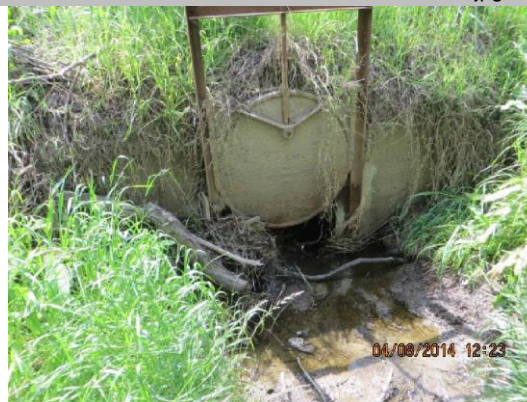
Photo 2 of 3 : UCIP_SP_2017_50077_60767.jpg

Pipe, concrete headwall, and slidegate on LS toe. Debris blocking closure of slidegate.

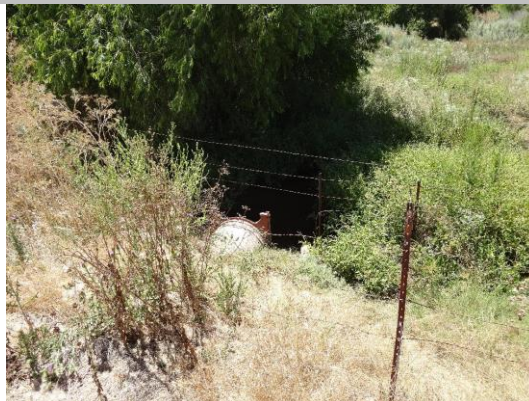
Photo 3 of 3 : UCIP_SP_2017_50077_75470.jpg

FS_ID:50077
DS_ID:19615
EP_NO: N/A
Repair Type: Non-Urgent
Crossing Status: Found
UCIP Comments: 7/19/2016 Potential LS slope damage--difficult to determine due to dense vegetation. Limited access on WS toe due to wire fence. (DWR UCIP - omagana)4/08/2014 Slide gate blocked by debris at LS toe. Flapgate won't close because of debris. Dense vegetation limits the inspector's visibility to identify signs of pipe failure (leaks) along the slope. Recommend removing vegetation along pipe alignment to conduct proper inspection of structure and appurtenances. (DWR UCIP - omagana)
FIELD_STRUCT_DESC: 36-inch corrugated metal drainage pipe through the levee, 10.3 feet below the crown. Slidegate located on landside (LS) toe and a flap gate located on the waterside (WS) end. Brass cap No. 90 BM is located on headwall on the LS. [Additional Reference(s): DWR Levee Log, 2002. USACE San Joaquin O&M Manuals: Unit No. 601, 1967, (HLM 6.90), Unit No. 601 Part I, 1967 (Amended in 1978), Unit No. 601 Part II, 1969, and Unit No. 601 Part III, 1969]

View of WS--fence limits access to flap gate.

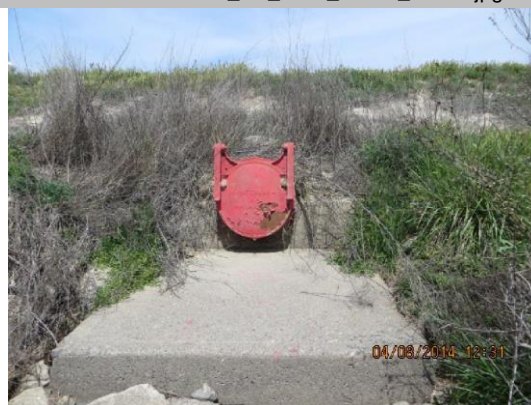
Photo 2 of 3 : UCIP_SP_2017_42851_60772.jpg

FS_ID:42851
DS_ID:19616
EP_NO: N/A
Repair Type: Non-Urgent
Crossing Status: Found
UCIP Comments: Pipe failing and corroded through at LS toe. Need to contact owner to determine status of crossing. Also dense vegetation limits the inspector's visibility to identify signs of pipe failure (leaks) along the landward slope. Recommend removing vegetation along pipe alignment to conduct proper inspection of structure.
FIELD_STRUCT_DESC: 24-inch CM stormdrain pipe through the levee, 5.1 feet below the crown. Flap gate on the waterward end. Brass cap No. 90 BM on headwall on the landward side. (USACE-1967). This entry matches the Drainage or Irrigation Structure referenced in O&M manual (HLM 7.21).
FS Date: 4/8/2014

Flapgate and concrete headwall on WS toe.

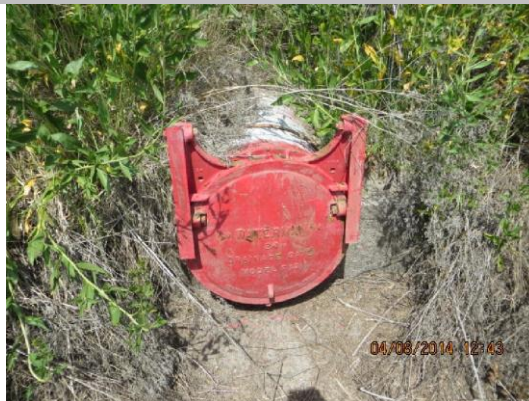
Photo 2 of 3 : UCIP_SP_2017_39161_60780.jpg

FS_ID:39161
DS_ID:19618
EP_NO: N/A
Repair Type: Non-Urgent
Crossing Status: Found
UCIP Comments: Dense vegetation limits the inspector's visibility to identify signs of pipe failure (leaks) along the slope. Recommend removing vegetation along pipe alignment to conduct proper inspection of structure and appurtenances.
FIELD_STRUCT_DESC: 24-inch CM stormdrain pipe through the levee, 8.0 feet below the crown. Flap gate on the waterward end. Brass cap No. 80 BM on headwall on the landward side. (USACE-1967). This entry matches the Drainage or Irrigation Structure referenced in O&M manual (HLM 7.46).
FS Date: 4/8/2014

Pipe and flapgate visible on WS toe.

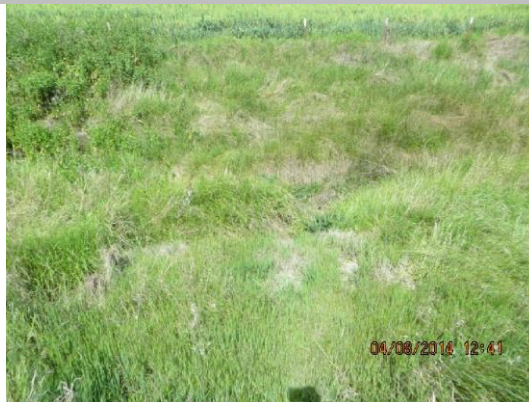
Photo 3 of 3 : UCIP_SP_2017_39161_60779.jpg

Concrete headwall and pipe visible off LS toe in heavy vegetation.

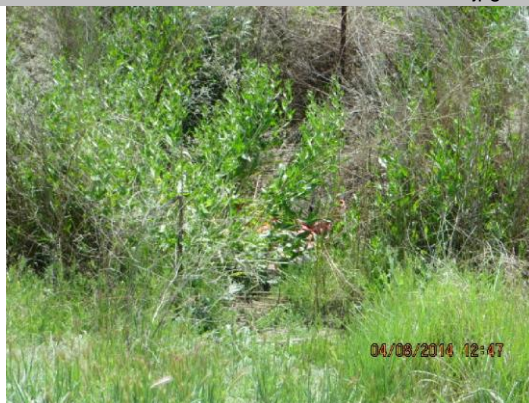
Photo 1 of 3 : UCIP_SP_2017_39243_60842.jpg

FS_ID:39243
DS_ID:19619
EP_NO: N/A
Repair Type: Non-Urgent
Crossing Status: Found
UCIP Comments: Dense vegetation limits the inspector's visibility to identify signs of pipe failure (leaks) along the slope. Recommend removing vegetation along pipe alignment to conduct proper inspection of structure.
FIELD_STRUCT_DESC: 24-inch CM pipe through the levee, 10.0 feet below the crown. Flap gate on the waterward end. Brass cap No. 80 BM on headwall on the landward side. (USACE-1967). This entry matches the Drainage or Irrigation Structure referenced in O&M manual (HLM 7.69).
FS Date: 4/8/2014

Flapgate and headwall at WS toe. Heavy vegetation on slopes.

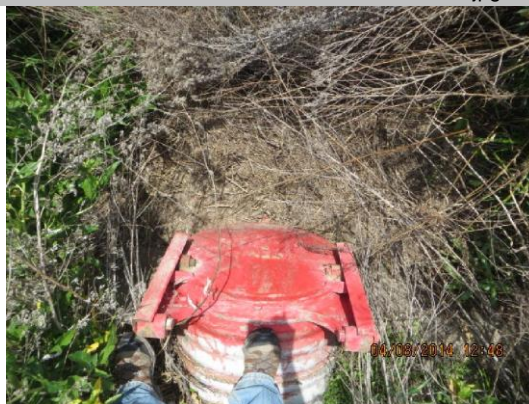
Photo 2 of 3 : UCIP_SP_2017_39243_60840.jpg

Flapgate and headwall at WS toe.

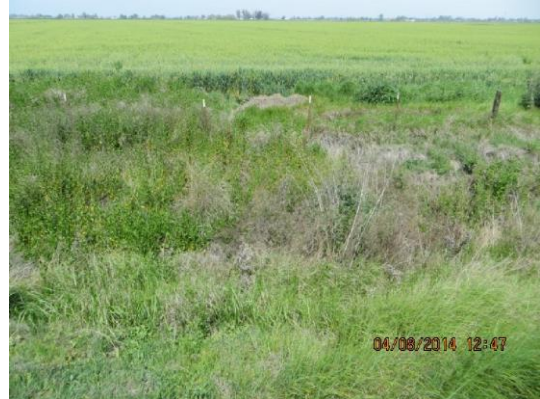
Photo 3 of 3 : UCIP_SP_2017_39243_60841.jpg

Item	DWR UCIP LMA Responsibility			37.299211 °	37.299211 °	
				-120.874415 °	-120.874415 °	
DWR ID						
Comment Code						
Inspector Comment						
FS_ID:39243 DS_ID:19619 EP_NO: N/A Repair Type: Non-Urgent Crossing Status: Found UCIP Comments: Dense vegetation limits the inspector's visibility to identify signs of pipe failure (leaks) along the slope. Recommend removing vegetation along pipe alignment to conduct proper inspection of structure. FIELD_STRUCT_DESC: 24-inch CM pipe through the levee, 10.0 feet below the crown. Flap gate on the waterward end. Brass cap No. 80 BM on headwall on the landward side. (USACE-1967). This entry matches the Drainage or Irrigation Structure referenced in O&M manual (HLM 7.69). FS Date: 4/8/2014

Concrete headwall at LS toe. Heavy vegetation on both slopes.

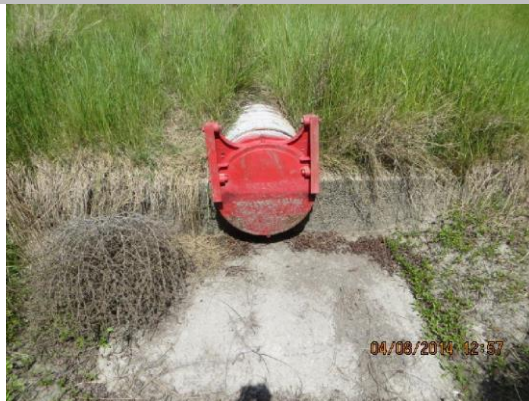
Photo 2 of 3 : UCIP_SP_2017_39244_60847.jpg

FS_ID:39244
DS_ID:19620
EP_NO: N/A
Repair Type: Non-Urgent
Crossing Status: Found
UCIP Comments: Dense vegetation limits the inspector's visibility to identify signs of pipe failure (leaks) along the slope. Recommend removing vegetation along pipe alignment to conduct proper inspection of structure.
FIELD_STRUCT_DESC: 24-inch CM stormdrain pipe through the levee, 8.0 feet below the crown. Flap gate on the waterward end. Brass cap No. 80 BM on headwall on the landward side. (USACE-1967). This entry matches the Drainage or Irrigation Structure referenced in O&M manual (HLM 8.07).
FS Date: 4/9/2014

Pipe, Headwall, and flapgate at WS toe.

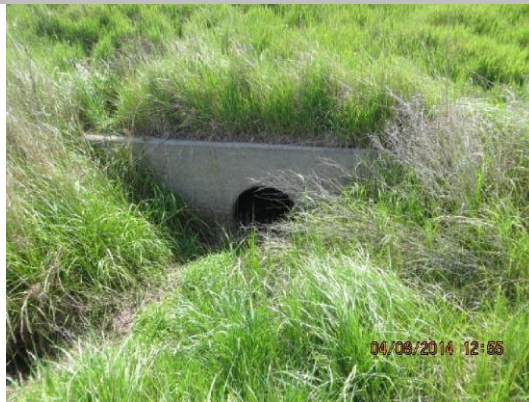
Photo 3 of 3 : UCIP_SP_2017_39244_60846.jpg

Pipe and concrete headwall on LS toe.

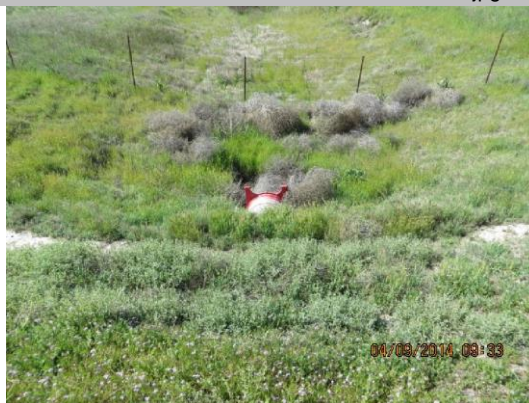
Photo 1 of 3 : UCIP_SP_2017_39245_60850.jpg

FS_ID:39245
DS_ID:19621
EP_NO: N/A
Repair Type: Non-Urgent
Crossing Status: Found
UCIP Comments: Dense vegetation limits the inspector's visibility to identify signs of pipe failure (leaks) along the slope. Recommend removing vegetation along pipe alignment to conduct proper inspection of structure. Sediment buildup at landward toe.
FIELD_STRUCT_DESC: 24-inch CM pipe through the levee, 9.5 feet below the crown. Flap gate on the waterward end. Brass cap No. 80 BM on headwall on the landward side. (USACE-1967). This entry matches the Drainage or Irrigation Structure referenced in O&M manual (HLM 8.41).
FS Date: 4/9/2014

Concrete headwall, pipe, and flapgate at WS toe.

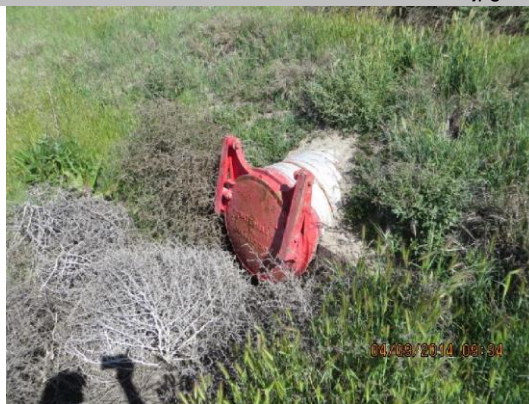
Photo 2 of 3 : UCIP_SP_2017_39245_60848.jpg

Concrete headwall, pipe, and flapgate at WS toe.

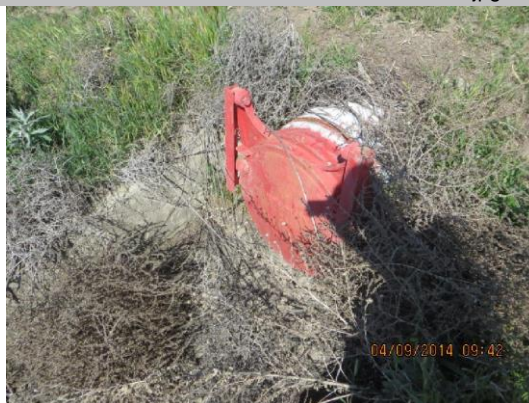
Photo 2 of 3 : UCIP_SP_2017_39246_60855.jpg

LM Start	8.57	Rating **	A/W	Issue No.	1220 (cont)
LM End	8.57	Issue Type +	Ma	Location *	WS
Category	Supplemental			GPS Latitude/Longitude	
				Start	End
Item	DWR UCIP LMA Responsibility			37.296552 °	37.296552 °
				-120.858596 °	-120.858596 °
DWR ID					
Comment Code					
Inspector Comment					
FS_ID:39246					
DS_ID:19622					
EP_NO: N/A					
Repair Type: No Action Needed					
Crossing Status: Found					
UCIP Comments:					
FIELD_STRUCT_DESC: 24-inch CM stormdrain pipe through the levee,					
9.0 feet below the crown. Flap gate on waterward end. Brass cap No.					
80 BM on headwall on the landward side. (USACE-1967). This entry					
matches the Drainage or Irrigation Structure referenced in O&M manual					
(HLM 8.61).					
FS Date: 4/9/2014

Pipe, Flapgate, and headwall on WS toe.

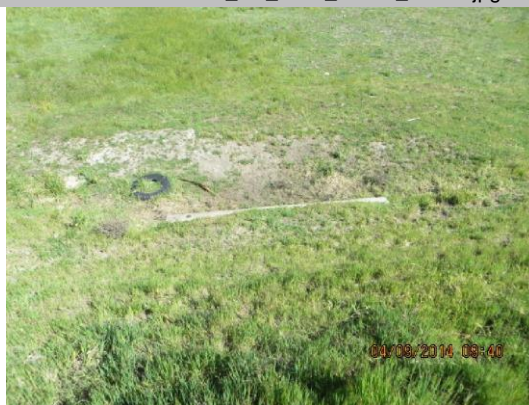
Photo 3 of 3 : UCIP_SP_2017_39246_60853.jpg

Pipe and headwall at LS toe.

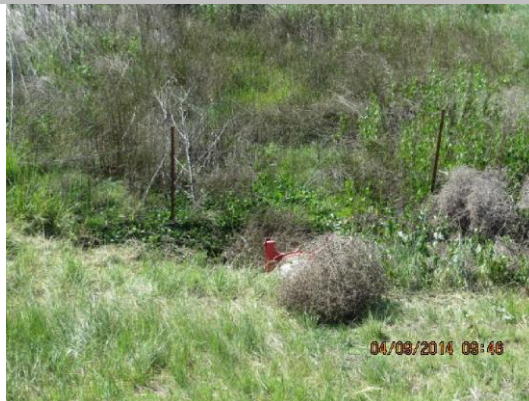
Photo 1 of 3 : UCIP_SP_2017_39247_60859.jpg

FS_ID:39247
DS_ID:19623
EP_NO: N/A
Repair Type: Non-Urgent
Crossing Status: Found
UCIP Comments: Dense vegetation limits the inspector's visibility to identify signs of pipe failure (leaks) along the slope. Recommend removing vegetation along pipe alignment to conduct proper inspection of structure.
FIELD_STRUCT_DESC: 24-inch CM stormdrain pipe through the levee, 9.1 feet below the crown. Flap gate on the waterward end. Brass cap No. 80 BM on headwall on the landward side. (USACE-1967). This entry matches the Drainage or Irrigation Structure referenced in O&M manual (HLM 8.93).
FS Date: 4/9/2014

Pipe, flapgate, and headwall on WS toe.

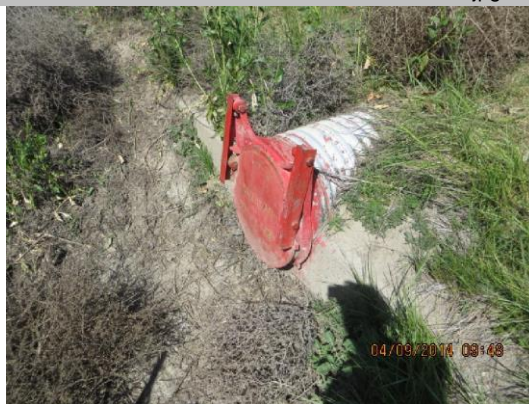
Photo 2 of 3 : UCIP_SP_2017_39247_60860.jpg

Pipe, flapgate, and headwall on WS toe.

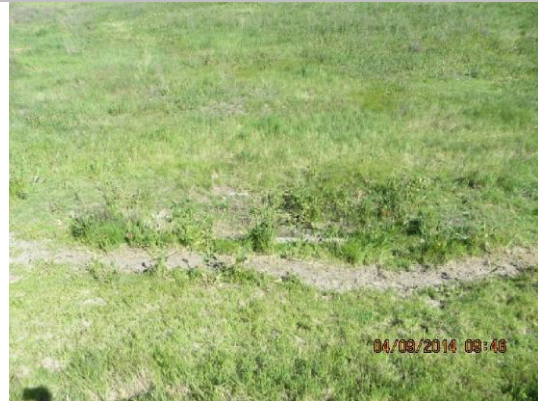
Photo 3 of 3 : UCIP_SP_2017_39247_60858.jpg

Item	DWR UCIP LMA Responsibility			37.297296 °		37.297296 °
				-120.852871 °		-120.852871 °
DWR ID						
Comment Code						
Inspector Comment						
FS_ID:39247 DS_ID:19623 EP_NO: N/A Repair Type: Non-Urgent Crossing Status: Found UCIP Comments: Dense vegetation limits the inspector's visibility to identify signs of pipe failure (leaks) along the slope. Recommend removing vegetation along pipe alignment to conduct proper inspection of structure. FIELD_STRUCT_DESC: 24-inch CM stormdrain pipe through the levee, 9.1 feet below the crown. Flap gate on the waterward end. Brass cap No. 80 BM on headwall on the landward side. (USACE-1967). This entry matches the Drainage or Irrigation Structure referenced in O&M manual (HLM 8.93). FS Date: 4/9/2014

Pipe and headwall visible on LS toe.

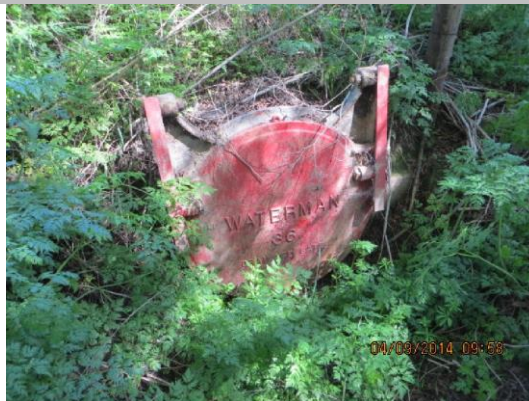
Photo 2 of 3 : UCIP_SP_2017_39249_60869.jpg

FS_ID:39249
DS_ID:19625
EP_NO: N/A
Repair Type: Non-Urgent
Crossing Status: Found
UCIP Comments: Dense vegetation limits the inspector's visibility to identify signs of pipe failure (leaks) along the slope. Recommend removing vegetation along pipe alignment to conduct proper inspection of structure. Some sediment buildup in pipe.
FIELD_STRUCT_DESC: 36-inch CM stormdrain pipe through the levee, 10.0 feet below the crown. Flap gate on the waterward end. Brass cap No. 80 BM on headwall on the landward side. (USACE-1967). This entry matches the Drainage or Irrigation Structure referenced in O&M manual (HLM 9.00).
FS Date: 4/9/2014

Pipe and flapgate visible on WS toe.

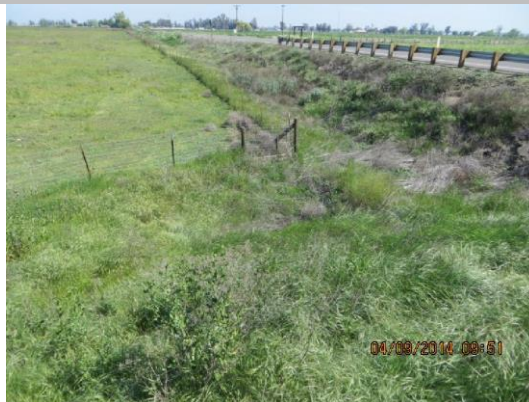
Photo 3 of 3 : UCIP_SP_2017_39249_60868.jpg

Pipe and headwall visible on LS toe.

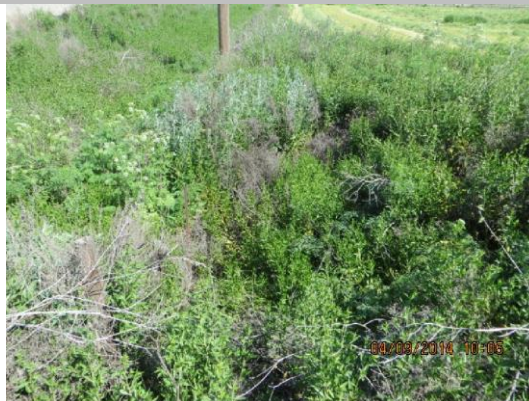
Photo 1 of 2 : UCIP_SP_2017_39250_60872.jpg

FS_ID:39250
DS_ID:19626
EP_NO: N/A
Repair Type: Non-Urgent
Crossing Status: Found
UCIP Comments: Dense vegetation limits the inspector's visibility to identify signs of pipe failure (leaks) along the slope. Recommend removing vegetation along pipe alignment to conduct proper inspection of structure.
FIELD_STRUCT_DESC: 24-inch CM stormdrain pipe through the levee, 10.0 feet below the crown. Flap gate on the waterward end. Brass cap No. 80 BM on headwall on the landward side. (USACE-1967). This entry matches the Drainage or Irrigation Structure referenced in O&M manual (HLM 9.03).
FS Date: 4/9/2014

Heavy vegetation on LS toe.

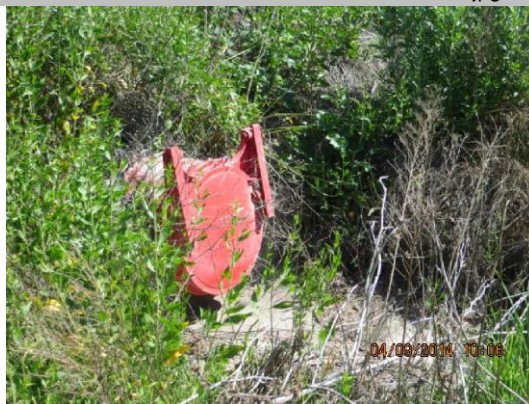
Photo 2 of 2 : UCIP_SP_2017_39250_60871.jpg

Pipe, concrete headwall, and flapgate at WS toe.

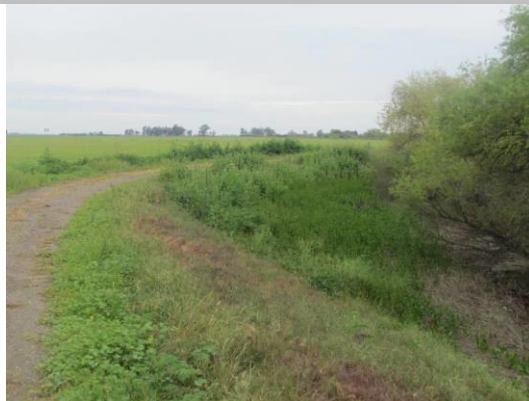
Photo 1 of 1 : SP_2017_NA0010_118_92_20170424_00279.jpg

LM Start	8.99	Rating **	U	Issue No.	92
LM End	9.43	Issue Type +	Ma	Location *	WS
Category	Earthen Levee			GPS Latitude/Longitude	
				Start	End
Item	Vegetation			37.297497 °	37.295310 °
				-120.851068 °	-120.843918 °
DWR ID	DWR_NA0010_01_s _ 2017_92				
Comment Code					
V2 : Remove the wild growth other than native grasses from the levee slopes.					
Inspector Comment

Looking southwest at dense veg on waterward slope.

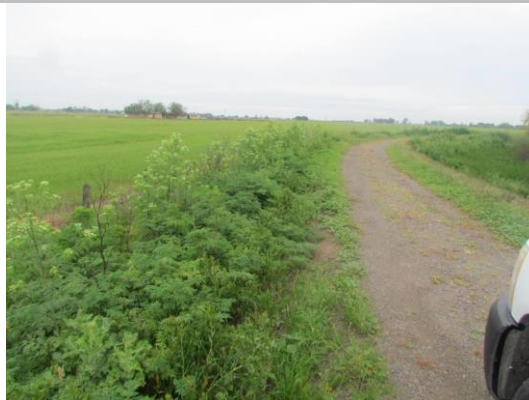
Photo 1 of 1 : SP_2017_NA0010_118_6_20170424_00280.jpg

LM Start	8.99	Rating **	U	Issue No.	6
LM End	9.61	Issue Type +	Ma	Location *	LS
Category	Earthen Levee			GPS Latitude/Longitude	
				Start	End
Item	Vegetation			37.297497 °	37.295138 °
				-120.851068 °	-120.840857 °
DWR ID	DWR_NA0010_01_s _ 2017_6				
Comment Code					
V2 : Remove the wild growth other than native grasses from the levee slopes.					
Inspector Comment

Looking south at dense veg on landward slope.

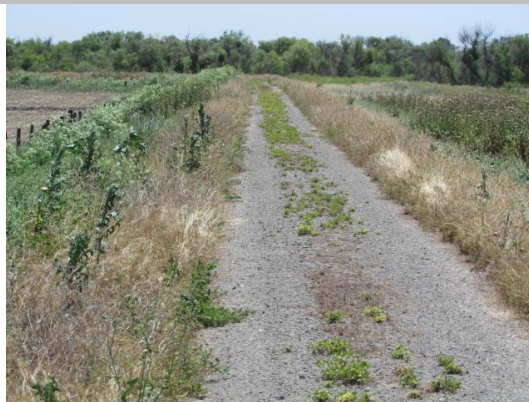
Photo 1 of 1 : SP_2017_NA0010_118_117_20170417_00028.jpg

LM Start	9.10	Rating **	M	Issue No.	117
LM End	9.78	Issue Type +	Ma	Location *	CR
Category	Earthen Levee			GPS Latitude/Longitude	
				Start	End
Item	Crown Surface / Depressions / Rutting			37.296725 °	37.293077 °
				-120.849438 °	-120.839170 °
DWR ID	DWR_NA0010_01_s _ 2012_117				
Comment Code					
C1 : Add appropriate material and re-grade the levee to bring the crown above the design elevation.					
Inspector Comment					
Control vegetation on levee crown.

Looking south at veg on levee crown.

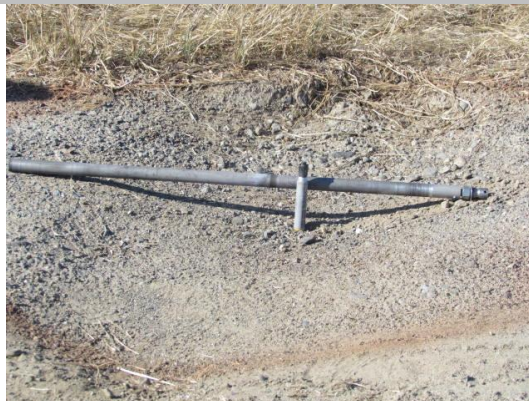
Photo 2 of 3 : SP_2017_NA0010_118_14_20170417_00013.jpg

LM Start	9.57	Rating **	M	Issue No.	14 (cont)	
LM End	9.57	Issue Type +	Ma	Location *	CR	
Category	Earthen Levee			GPS Latitude/Longitude		
				Start		End
Item	Crown Surface / Depressions / Rutting			37.295517 °		37.295517 °
				-120.841452 °		-120.841452 °
DWR ID	DWR_NA0010_01_s_2015_14					
Comment Code						
C2 : Repair depressions or ruts in the crown or slope.						
Inspector Comment						
Depression greater than 3" deep by 18" wide by 18" long on levee crown

Looking west at depression greater than three inches on levee crown.

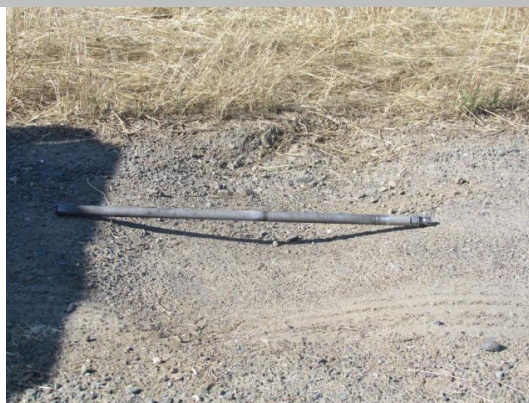
Photo 3 of 3 : SP_2017_NA0010_118_14_20170417_00014.jpg

Looking west at depression on levee crown.

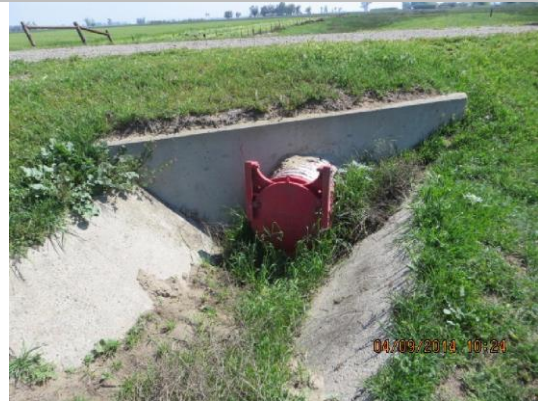
Photo 1 of 1 : UCIP_SP_2017_33683_60880.jpg

LM Start	9.64	Rating **	A/W	Issue No.	1226	
LM End	9.64	Issue Type +	Ma	Location *	CR	
Category	Supplemental			GPS Latitude/Longitude		
				Start	End	
Item	DWR UCIP LMA Responsibility			37.294845 °	37.294845 °	
				-120.840580 °	-120.840580 °	
DWR ID						
Comment Code						
Inspector Comment						
FS_ID:33683						
DS_ID:19628						
EP_NO: N/A						
Repair Type: No Action Needed						
Crossing Status: Found						
UCIP Comments:						
FIELD_STRUCT_DESC: 24-inch CM stormdrain pipe through the levee,						
4.5 feet below the crown. Flap gate on the waterward end. Brass cap						
No. 80 BM on headwall on the landward side. (USACE-1967). This						
entry matches the Drainage or Irrigation Structure referenced in O&M						
manual (HLM 9.67).						
FS Date: 4/9/2014

Pipe, flapgate, and headwall visible on WS toe.

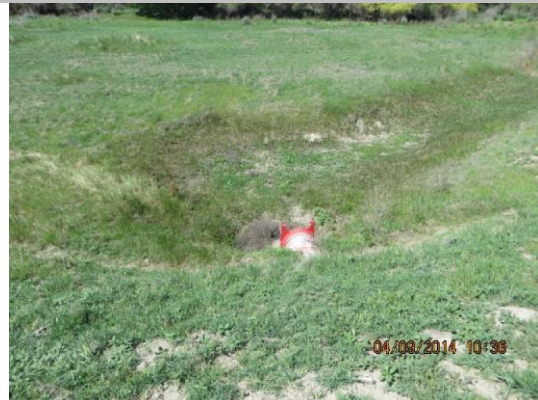
Photo 1 of 3 : UCIP_SP_2017_39253_60884.jpg

LM Start	10.20	Rating **	M	Issue No.	1227
LM End	10.20	Issue Type +	Ma	Location *	CR
Category	Supplemental			GPS Latitude/Longitude	
				Start	End
Item	DWR UCIP LMA Responsibility			37.287511 °	37.287511 °
				-120.840251 °	-120.840251 °
DWR ID					
Comment Code					
Inspector Comment					
FS_ID:39253 DS_ID:19629 EP_NO: N/A Repair Type: Non-Urgent Crossing Status: Found UCIP Comments: Dense vegetation blocks waterward and landward toes Recommend removing vegetation from both toes. Also sediment buildup in pipe visible from landward side. FIELD_STRUCT_DESC: 24-inch CM stormdrain pipe through the levee, 9.0 feet below the crown. Flap gate on the waterward end. Brass cap No. 69 BM on headwall on the landward side. (USACE-1967). This entry matches the Drainage or Irrigation Structure referenced in O&M manual (HLM 10.23). FS Date: 4/9/2014

Pipe, headwall, and flapgate on WS toe.

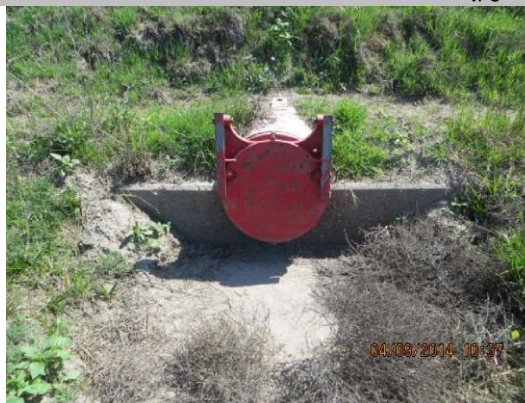
Photo 2 of 3 : UCIP_SP_2017_39253_60886.jpg

LM Start	10.20	Rating **	M	Issue No.	1227 (cont)
LM End	10.20	Issue Type +	Ma	Location *	CR
Category	Supplemental			GPS Latitude/Longitude	
				Start	End
Item	DWR UCIP LMA Responsibility			37.287511 °	37.287511 °
				-120.840251 °	-120.840251 °
DWR ID					
Comment Code					
Inspector Comment					
FS_ID:39253					
DS_ID:19629					
EP_NO: N/A					
Repair Type: Non-Urgent					
Crossing Status: Found					
UCIP Comments: Dense vegetation blocks waterward and landward toes Recommend removing vegetation from both toes. Also sediment buildup in pipe visible from landward side.					
FIELD_STRUCT_DESC: 24-inch CM stormdrain pipe through the levee, 9.0 feet below the crown. Flap gate on the waterward end. Brass cap No. 69 BM on headwall on the landward side. (USACE-1967). This entry matches the Drainage or Irrigation Structure referenced in O&M manual (HLM 10.23).					
FS Date: 4/9/2014

Pipe, headwall, and flapgate at WS toe.

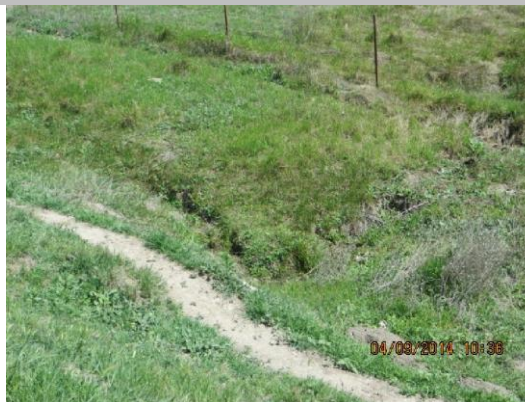
Photo 3 of 3 : UCIP_SP_2017_39253_60885.jpg

Pipe and headwall at LS toe.

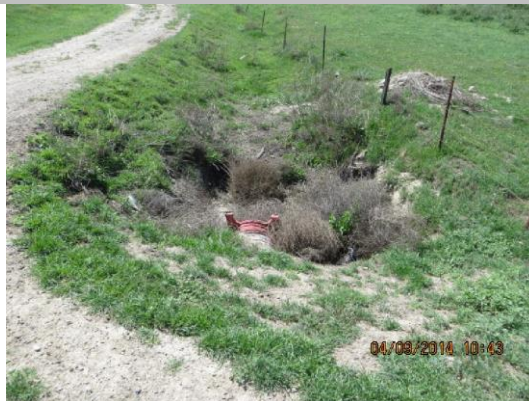
Photo 1 of 3 : UCIP_SP_2017_33687_60890.jpg

LM Start	10.68	Rating **	A/W	Issue No.	1228
LM End	10.68	Issue Type +	Ma	Location *	CR
Category	Supplemental			GPS Latitude/Longitude	
				Start	End
Item	DWR UCIP LMA Responsibility			37.283740 °	37.283740 °
				-120.833452 °	-120.833452 °
DWR ID					
Comment Code					
Inspector Comment					
FS_ID:33687 DS_ID:19630 EP_NO: N/A Repair Type: No Action Needed Crossing Status: Found UCIP Comments: FIELD_STRUCT_DESC: 24-inch CM stormdrain pipe through the levee, 7.0 feet below the crown. Flap gate on the waterward end. Brass cap No. 68 BM on headwall on the landward side. (USACE-1967). This entry matches the Drainage or Irrigation Structure referenced in O&M manual (HLM 10.72). FS Date: 4/9/2014

Pipe and flapgate on Ws toe.

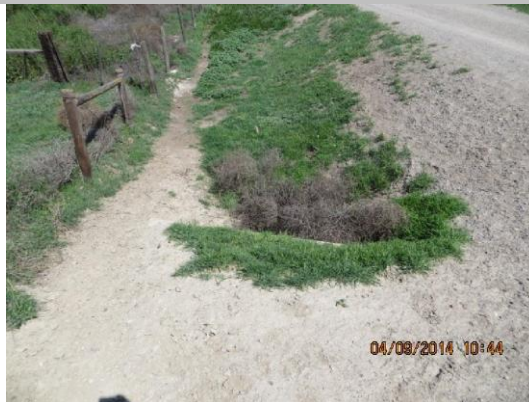
Photo 2 of 3 : UCIP_SP_2017_33687_60889.jpg

Pipe and headwall on LS toe.

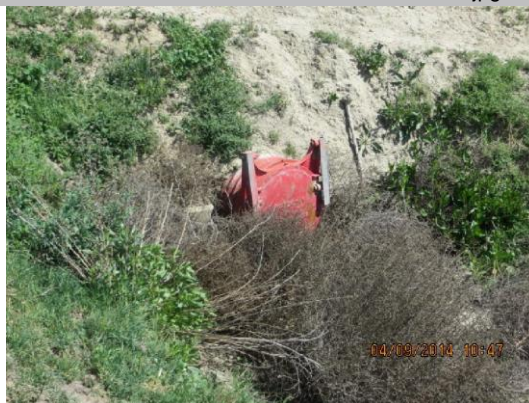
Photo 2 of 3 : UCIP_SP_2017_39254_60893.jpg

LM Start	10.69	Rating **	A/W	Issue No.	1229 (cont)
LM End	10.69	Issue Type +	Ma	Location *	CR
Category	Supplemental			GPS Latitude/Longitude	
				Start	End
Item	DWR UCIP LMA Responsibility			37.283710 °	37.283710 °
				-120.833329 °	-120.833329 °
DWR ID					
Comment Code					
Inspector Comment					
FS_ID:39254					
DS_ID:19631					
EP_NO: N/A					
Repair Type: No Action Needed					
Crossing Status: Found					
UCIP Comments:					
FIELD_STRUCT_DESC: 24-inch CM stormdrain pipe through the levee, 7.0 feet below the crown. Flap gate on the waterward end. Brass cap No. 67 BM on headwall on the landward side. (USACE-1967). This entry matches the Drainage or Irrigation Structure referenced in O&M manual (HLM 10.72).					
FS Date: 4/9/2014

Headwall, pipe, and flapgate on WS toe.

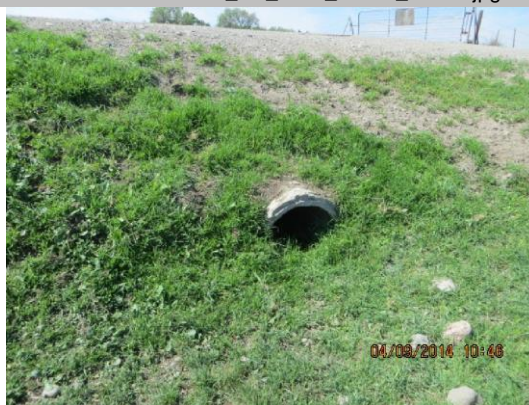
Photo 3 of 3 : UCIP_SP_2017_39254_60895.jpg

Concrete pipe visible on LS slope.

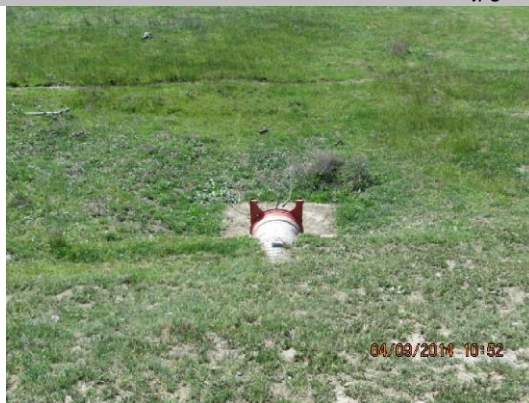
Photo 1 of 3 : UCIP_SP_2017_39255_60897.jpg

FS_ID:39255
DS_ID:19632
EP_NO: N/A
Repair Type: Non-Urgent
Crossing Status: Found
UCIP Comments: Dense vegetation blocks landward headwall.
Recommend removing excess vegetation on landward toe.
FIELD_STRUCT_DESC: 24-inch CM stormdrain pipe through the levee, 6.0 feet below the crown. Flap gate on the waterward end. Brass cap No. 66 BM on headwall on the landward side. (USACE-1967). This entry matches the Drainage or Irrigation Structure referenced in O&M manual (HLM 11.00).
FS Date: 4/9/2014

Pipe, headwall, and flapgate on WS toe.

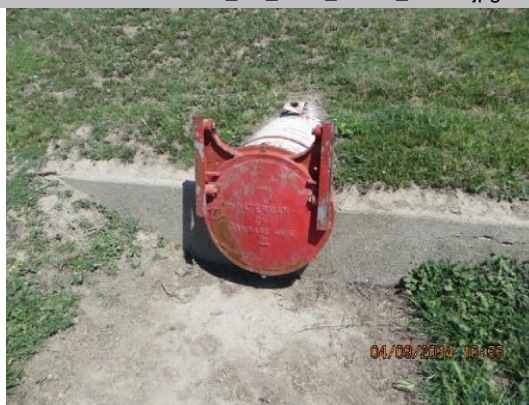
Photo 2 of 3 : UCIP_SP_2017_39255_60899.jpg

Pipe, headwall, and flapgate on WS toe.

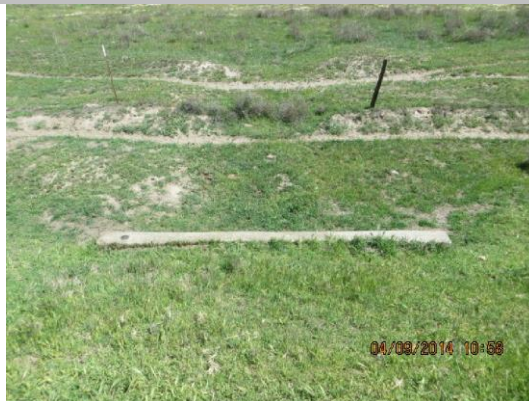
Photo 2 of 3 : UCIP_SP_2017_33690_60902.jpg

LM Start	11.14	Rating **	A/W	Issue No.	1231 (cont)	
LM End	11.14	Issue Type +	Ma	Location *	CR	
Category	Supplemental			GPS Latitude/Longitude		
				Start	End	
Item	DWR UCIP LMA Responsibility			37.281813 °	37.281813 °	
				-120.825409 °	-120.825409 °	
DWR ID						
Comment Code						
Inspector Comment						
FS_ID:33690						
DS_ID:19633						
EP_NO: N/A						
Repair Type: No Action Needed						
Crossing Status: Found						
UCIP Comments:						
FIELD_STRUCT_DESC: 24-inch CM stormdrain pipe through the levee,						
5.0 feet below the crown. Flap gate on the waterward end. Brass cap						
No. 65 BM on headwall on the landward side. (USACE-1967). This						
entry matches the Drainage or Irrigation Structure referenced in O&M						
manual (HLM 11.18).						
FS Date: 4/9/2014

Pipe and headwall at LS toe.

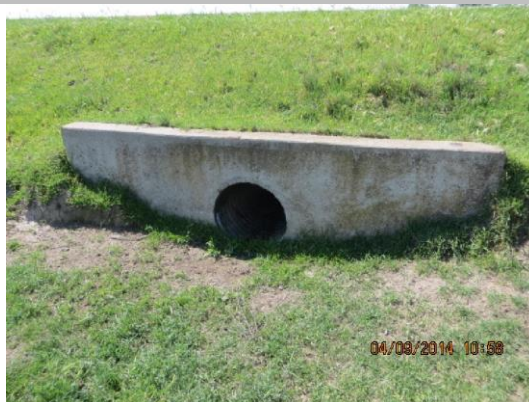
Photo 3 of 3 : UCIP_SP_2017_33690_60901.jpg

Pipe and headwall at LS toe.

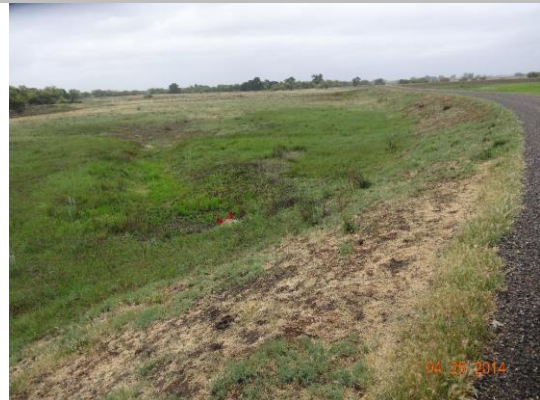
Photo 1 of 3 : UCIP_SP_2017_36103_65362.jpg

LM Start	11.49	Rating **	M	Issue No.	1233
LM End	11.49	Issue Type +	Ma	Location *	CR
Category	Supplemental			GPS Latitude/Longitude	
				Start	End
Item	DWR UCIP LMA Responsibility			37.273787 °	37.273787 °
				-120.825519 °	-120.825519 °
DWR ID					
Comment Code					
Inspector Comment					
FS_ID:36103 DS_ID:19634 EP_NO: N/A Repair Type: Non-Urgent Crossing Status: Found UCIP Comments: Need to contact owner--landward side has been buried. It appears that soil was removed from levee toe, immediately upstream, and used to pile soil at landward side at crossing. FIELD_STRUCT_DESC: 24-inch CM pipe through the levee, 10.0 feet below the crown. Flap gate on the waterward end. Brass cap No. 62 BM on headwall on the landward side. (USACE-1967). This entry matches the Drainage or Irrigation Structure referenced in O&M manual (HLM 11.48). FS Date: 4/25/2014

View of waterward side.

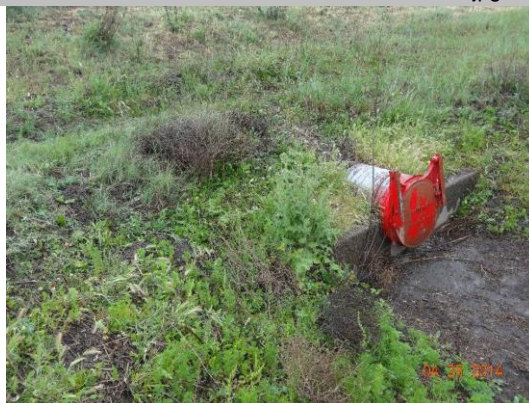
Photo 2 of 3 : UCIP_SP_2017_36103_65364.jpg

View of concrete headwall and flap gate visible on waterward side.

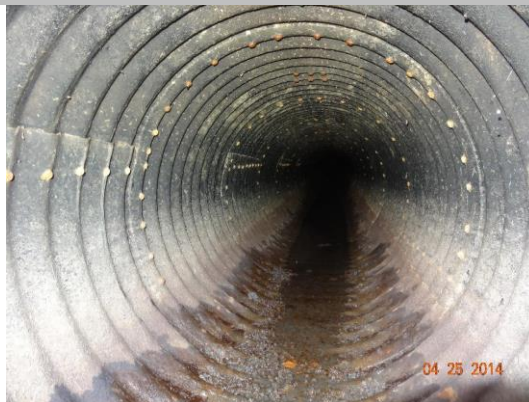
Photo 3 of 3 : UCIP_SP_2017_36103_65363.jpg

Inside view of pipe from waterward side.

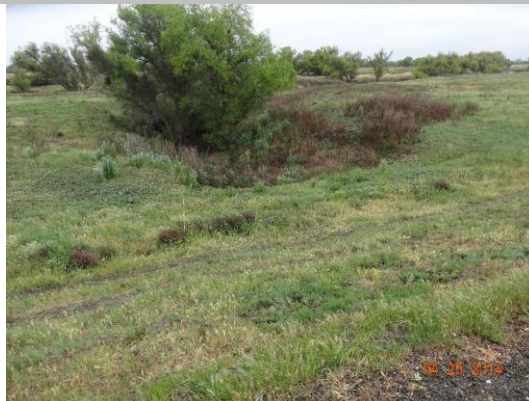
Photo 1 of 3 : UCIP_SP_2017_36105_65372.jpg

FS_ID:36105
DS_ID:19635
EP_NO: N/A
Repair Type: Non-Urgent
Crossing Status: Found
UCIP Comments: Crossing is non-functional --landward side is buried. Debris found on landward side (channel). Dense vegetation found on waterward slope. Recommend contacting owner to determine status of crossing. If crossing is no longer used need to coordinate with CVFPB for proper abandonment.
FIELD_STRUCT_DESC: 24-inch CM pipe through the levee, 17.0 feet below the crown. Flap gate on the waterward end. Brass cap No. 61 BM on headwall on the landward side. (USACE-1967). This entry matches the Drainage or Irrigation Structure referenced in O&M manual (HLM 11.76).
FS Date: 4/25/2014

View of waterward side.

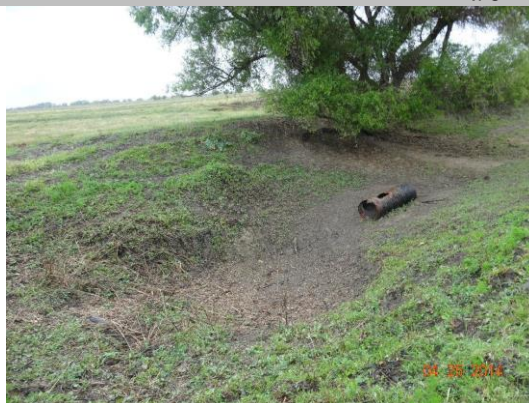
Photo 2 of 3 : UCIP_SP_2017_36105_65371.jpg

Landward side of crossing buried--damage pipe section visible on landward side.

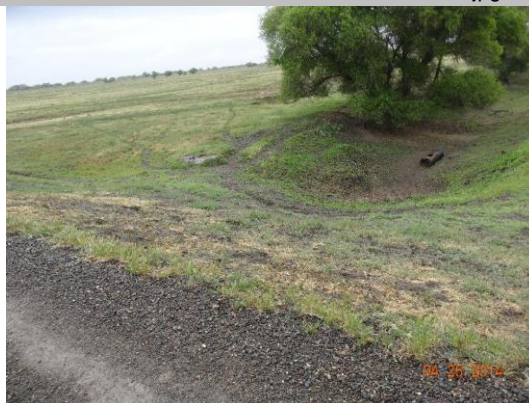
Photo 3 of 3 : UCIP_SP_2017_36105_65373.jpg

Comment Code					
Inspector Comment					
FS_ID:36105 DS_ID:19635 EP_NO: N/A Repair Type: Non-Urgent Crossing Status: Found UCIP Comments: Crossing is non-functional --landward side is buried. Debris found on landward side (channel). Dense vegetation found on waterward slope. Recommend contacting owner to determine status of crossing. If crossing is no longer used need to coordinate with CVFPB for proper abandonment. FIELD_STRUCT_DESC: 24-inch CM pipe through the levee, 17.0 feet below the crown. Flap gate on the waterward end. Brass cap No. 61 BM on headwall on the landward side. (USACE-1967). This entry matches the Drainage or Irrigation Structure referenced in O&M manual (HLM 11.76). FS Date: 4/25/2014

View of landward side.

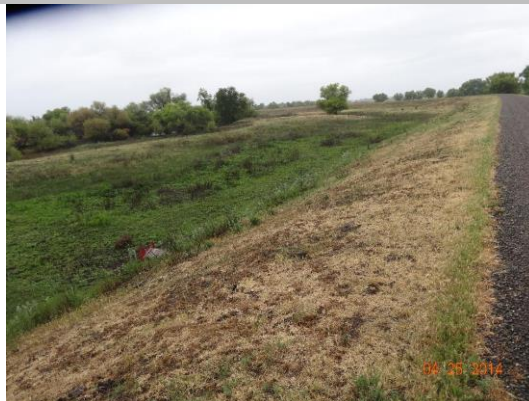
Photo 1 of 3 : UCIP_SP_2017_36106_65378.jpg

FS_ID:36106
 DS_ID:19636
 EP_NO: N/A
 Repair Type: Non-Urgent
 Crossing Status: Found
 UCIP Comments: Crossing is non-functional --landward side is buried. Dense vegetation found on waterward slope. Recommend contacting owner to determine status of crossing. If crossing is no longer used need to coordinate with CVFPB for proper abandonment.
 FIELD_STRUCT_DESC: 24-inch CM pipe through the levee, 12.4 feet below the crown. Flap gate on the waterward end. Brass cap No. 60 BM on headwall on the landward side. (USACE-1967). This entry matches the Drainage or Irrigation Structure referenced in O&M manual (HLM 12.11).
 FS Date: 4/25/2014

View of waterward side--flap gate visible on waterward toe.

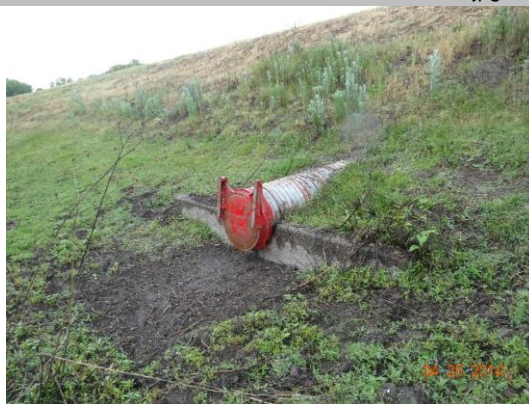
Photo 2 of 3 : UCIP_SP_2017_36106_65379.jpg

Flap gate and concrete headwall visible on waterward side.

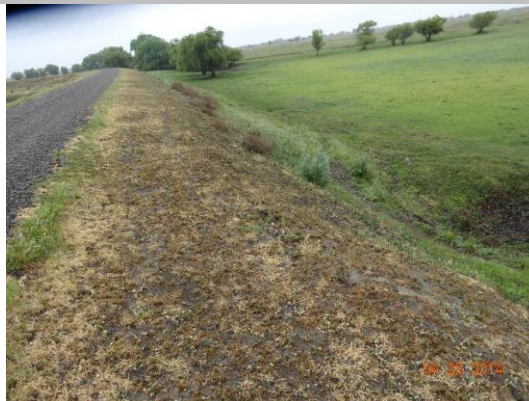
Photo 3 of 3 : UCIP_SP_2017_36106_65377.jpg

Item	DWR UCIP LMA Responsibility			37.265336 °	37.265336 °	
				-120.826591 °	-120.826591 °	
DWR ID						
Comment Code						
Inspector Comment						
FS_ID:36106 DS_ID:19636 EP_NO: N/A Repair Type: Non-Urgent Crossing Status: Found UCIP Comments: Crossing is non-functional --landward side is buried. Dense vegetation found on waterward slope. Recommend contacting owner to determine status of crossing. If crossing is no longer used need to coordinate with CVFPB for proper abandonment. FIELD_STRUCT_DESC: 24-inch CM pipe through the levee, 12.4 feet below the crown. Flap gate on the waterward end. Brass cap No. 60 BM on headwall on the landward side. (USACE-1967). This entry matches the Drainage or Irrigation Structure referenced in O&M manual (HLM 12.11). FS Date: 4/25/2014

View of landward side.

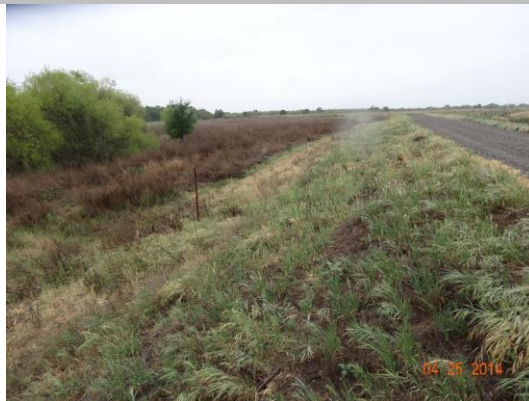
Photo 1 of 3 : UCIP_SP_2017_36146_65412.jpg

Comment Code					
Inspector Comment					
FS_ID:36146 DS_ID:19637 EP_NO: N/A Repair Type: Non-Urgent Crossing Status: Found UCIP Comments: Concrete headwall on landward side blocked by debris. Dense vegetation limits the inspector's visibility to identify signs of pipe failure (leaks) along the landward slope. Recommend removing vegetation along pipe alignment to conduct proper inspection of crossing. FIELD_STRUCT_DESC: 24-inch CM pipe through the levee, 9.5 feet below the crown. Flap gate on the waterward end. Brass cap No. 60 BM on headwall on the landward side. (USACE-1967). This entry matches the Drainage or Irrigation Structure referenced in O&M manual (HLM 12.94). FS Date: 4/25/2014

View of waterward side.

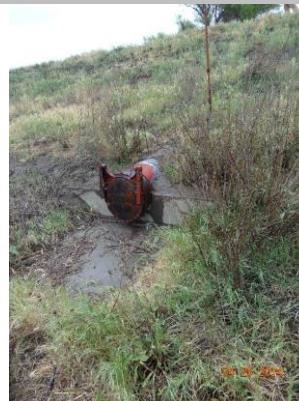
Photo 2 of 3 : UCIP_SP_2017_36146_65411.jpg

Flap gate and concrete headwall visible on waterward side.

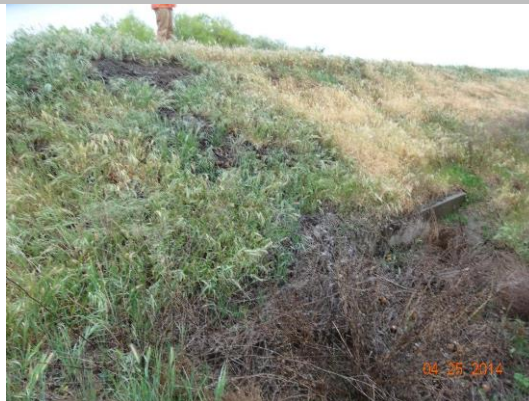
Photo 3 of 3 : UCIP_SP_2017_36146_65410.jpg

Item	DWR UCIP LMA Responsibility			37.256873 °	37.256873 °	
				-120.821277 °	-120.821277 °	
DWR ID						
Comment Code						
Inspector Comment						
FS_ID:36146						
DS_ID:19637						
EP_NO: N/A						
Repair Type: Non-Urgent						
Crossing Status: Found						
UCIP Comments: Concrete headwall on landward side blocked by debris. Dense vegetation limits the inspector's visibility to identify signs of pipe failure (leaks) along the landward slope. Recommend removing vegetation along pipe alignment to conduct proper inspection of crossing.						
FIELD_STRUCT_DESC: 24-inch CM pipe through the levee, 9.5 feet below the crown. Flap gate on the waterward end. Brass cap No. 60 BM on headwall on the landward side. (USACE-1967). This entry matches the Drainage or Irrigation Structure referenced in O&M manual (HLM 12.94).						
FS Date: 4/25/2014

View of landward side--concrete headwall visible covered by dense vegetation.

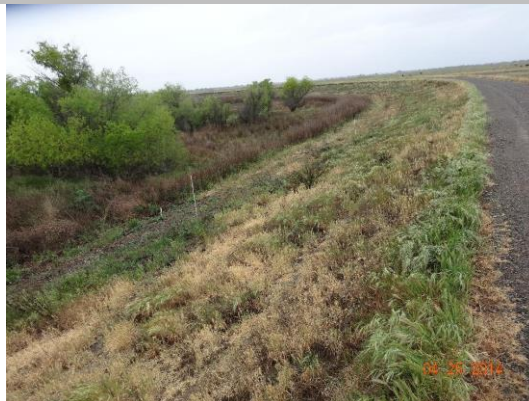
Photo 1 of 3 : UCIP_SP_2017_36109_65389.jpg

FS_ID:36109
DS_ID:19638
EP_NO: N/A
Repair Type: Non-Urgent
Crossing Status: Found
UCIP Comments: Dense vegetation limits the inspector's visibility to identify signs of pipe failure (leaks) along the landward slope. Concrete headwall blocked by debris located on landward toe. Recommend clearing debris from landward slope and toe.
FIELD_STRUCT_DESC: 24-inch CM pipe through the levee, 14.2 feet below the crown. Flap gate on the waterward end. Brass cap No. 60 BM on headwall on the landward side. (USACE-1967). This entry matches the Drainage or Irrigation Structure referenced in O&M manual (HLM 13.48).
FS Date: 4/25/2014

View of waterward side.

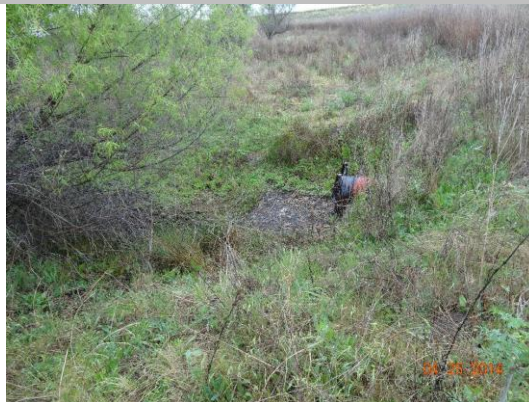
Photo 2 of 3 : UCIP_SP_2017_36109_65387.jpg

View of flap gate and pipe through levee on waterward side.
