**Flood Control Project Maintenance
Levee Inspections**

Maintenance Issue Types Only, Levee Inspection Report By Mile - Spring 2017

Lower San Joaquin Levee District

Waterway	Bank	Unit Miles	Inspection Start/End	Inspector
Unit No. 01 San Joaquin River	Right	22.52	04/17/2017 04/20/2017	Richard Willoughby

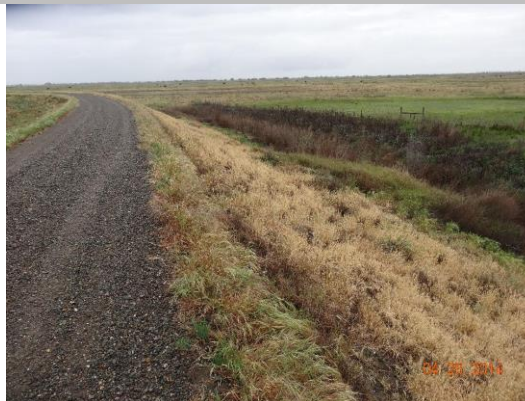
Photo 3 of 3 : UCIP_SP_2017_36109_65388.jpg

Item	DWR UCIP LMA Responsibility			37.251590 °		37.251590 °
				-120.814354 °		-120.814354 °
DWR ID						
Comment Code						
Inspector Comment						
FS_ID:36109 DS_ID:19638 EP_NO: N/A Repair Type: Non-Urgent Crossing Status: Found UCIP Comments: Dense vegetation limits the inspector's visibility to identify signs of pipe failure (leaks) along the landward slope. Concrete headwall blocked by debris located on landward toe. Recommend clearing debris from landward slope and toe. FIELD_STRUCT_DESC: 24-inch CM pipe through the levee, 14.2 feet below the crown. Flap gate on the waterward end. Brass cap No. 60 BM on headwall on the landward side. (USACE-1967). This entry matches the Drainage or Irrigation Structure referenced in O&M manual (HLM 13.48). FS Date: 4/25/2014

View of landward side.

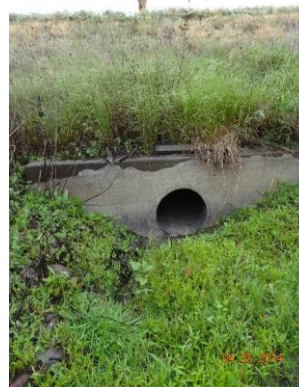
Photo 3 of 3 : UCIP_SP_2017_39256_65416.jpg

Item	DWR UCIP LMA Responsibility			37.250138 °		37.250138 °
				-120.814720 °		-120.814720 °
DWR ID						
Comment Code						
Inspector Comment						
FS_ID:39256 DS_ID:19639 EP_NO: N/A Repair Type: Non-Urgent Crossing Status: Found UCIP Comments: No access to waterward toe due to fence. Unable to find the concrete headwall and flap gate on waterward side past fence. Also dense vegetation limits the inspector's visibility to identify signs of pipe failure (leaks) along the waterward slope. Recommend removing vegetation along pipe alignment to conduct proper inspection of structure. Also need access past fence on waterward side. FIELD_STRUCT_DESC: 24-inch CM pipe through the levee, 14.5 feet below the crown. Flap gate on the waterward end. Brass cap No. 60 BM on headwall on the landward side. (USACE-1967). This entry matches the Drainage or Irrigation Structure referenced in O&M manual (HLM 13.58). FS Date: 4/25/2014

Concrete headwall visible from landward side.

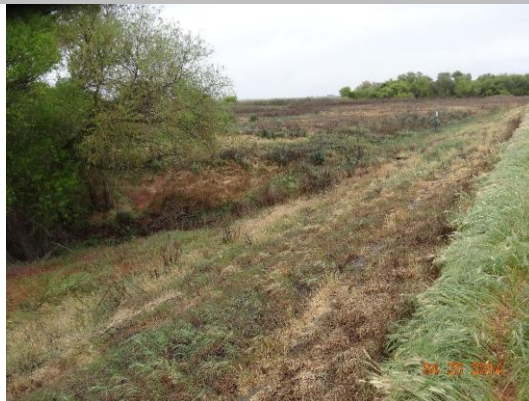
Photo 1 of 3 : UCIP_SP_2017_36166_65449.jpg

FS_ID:36166
DS_ID:19641
EP_NO: N/A
Repair Type: Non-Urgent
Crossing Status: Found
UCIP Comments: Dense vegetation limits the inspector's visibility to identify signs of pipe failure (leaks) along the slopes. Recommend removing vegetation along pipe alignment to conduct proper inspection of structure.
FIELD_STRUCT_DESC: 24-inch CM pipe through the levee, 13.0 feet below the crown. Flap gate on the waterward end. Brass cap No. 60 BM on headwall on the landward side. (USACE-1967). This entry matches the Drainage or Irrigation Structure referenced in O&M manual (HLM 14.21).
FS Date: 4/25/2014

View of waterward side.

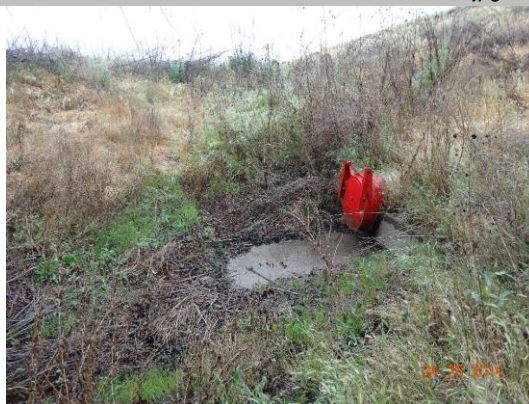
Photo 2 of 3 : UCIP_SP_2017_36166_65452.jpg

View of concrete headwall, concrete apron, and flap gate on waterward side.

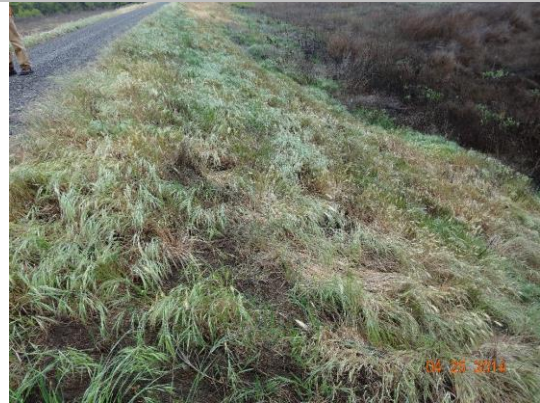
Photo 3 of 3 : UCIP_SP_2017_36166_65448.jpg

Item	DWR UCIP LMA Responsibility			37.242225 °	37.242225 °	
				-120.817665 °	-120.817665 °	
DWR ID						
Comment Code						
Inspector Comment						
FS_ID:36166 DS_ID:19641 EP_NO: N/A Repair Type: Non-Urgent Crossing Status: Found UCIP Comments: Dense vegetation limits the inspector's visibility to identify signs of pipe failure (leaks) along the slopes. Recommend removing vegetation along pipe alignment to conduct proper inspection of structure. FIELD_STRUCT_DESC: 24-inch CM pipe through the levee, 13.0 feet below the crown. Flap gate on the waterward end. Brass cap No. 60 BM on headwall on the landward side. (USACE-1967). This entry matches the Drainage or Irrigation Structure referenced in O&M manual (HLM 14.21). FS Date: 4/25/2014

View of landward side.

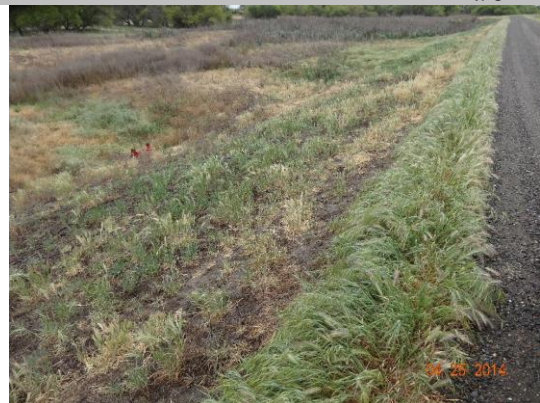
Photo 1 of 3 : UCIP_SP_2017_36167_65455.jpg

Comment Code					
Inspector Comment					
FS_ID:36167 DS_ID:19642 EP_NO: N/A Repair Type: Non-Urgent Crossing Status: Found UCIP Comments: Dense vegetation limits the inspector's visibility to identify signs of pipe failure (leaks) along the landward slope and toe. Recommend removing vegetation along pipe alignment to conduct proper inspection of structure. FIELD_STRUCT_DESC: 24-inch CM pipe through the levee, 9.7 feet below the crown. Flap gate on the waterward end. Brass cap No. 60 BM on headwall on the landward side. (USACE-1967). This entry matches the Drainage or Irrigation Structure referenced in O&M manual (HLM 14.65). FS Date: 4/25/2014

View of waterward side.

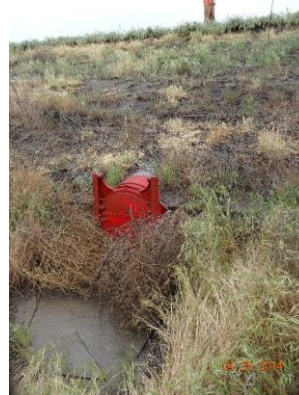
Photo 2 of 3 : UCIP_SP_2017_36167_65454.jpg

FS_ID:36167
DS_ID:19642
EP_NO: N/A
Repair Type: Non-Urgent
Crossing Status: Found
UCIP Comments: Dense vegetation limits the inspector's visibility to identify signs of pipe failure (leaks) along the landward slope and toe. Recommend removing vegetation along pipe alignment to conduct proper inspection of structure.
FIELD_STRUCT_DESC: 24-inch CM pipe through the levee, 9.7 feet below the crown. Flap gate on the waterward end. Brass cap No. 60 BM on headwall on the landward side. (USACE-1967). This entry matches the Drainage or Irrigation Structure referenced in O&M manual (HLM 14.65).
FS Date: 4/25/2014

Flap gate, concrete headwall, and concrete apron located on waterward toe.

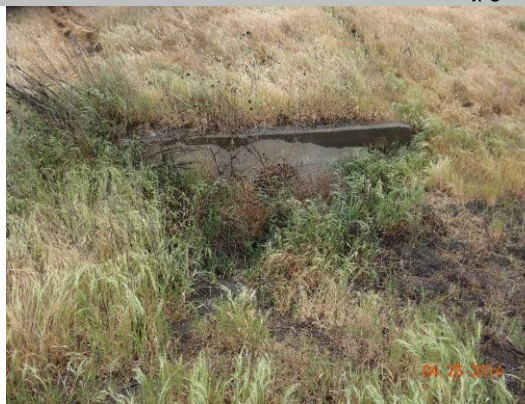
Photo 3 of 3 : UCIP_SP_2017_36167_65453.jpg

Concrete headwall located on landward toe.

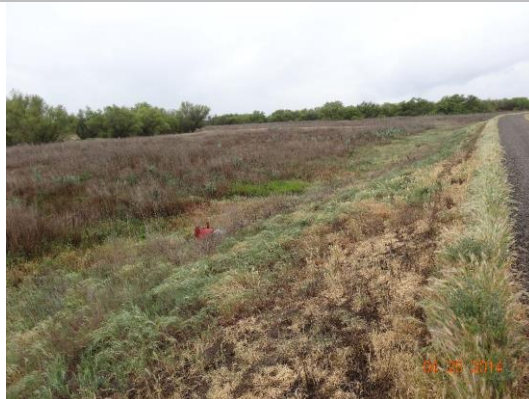
Photo 1 of 3 : UCIP_SP_2017_36168_65459.jpg

FS_ID:36168
DS_ID:19643
EP_NO: N/A
Repair Type: Non-Urgent
Crossing Status: Found
UCIP Comments: Dense vegetation limits the inspector's visibility to identify signs of pipe failure (leaks) along the landward slope. Recommend removing vegetation along pipe alignment to conduct proper inspection of structure.
FIELD_STRUCT_DESC: 24-inch CM pipe through the levee, 9.2 feet below the crown. Flap gate on the waterward end. Brass cap No. 60 BM on headwall on the landward side. (USACE-1967). This entry matches the Drainage or Irrigation Structure referenced in O&M manual (HLM 15.29).
FS Date: 4/25/2014

View of waterward side.

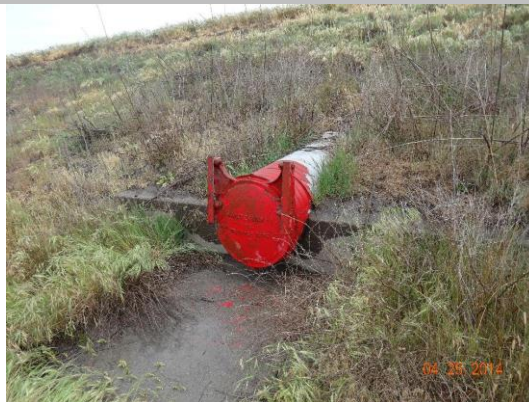
Photo 2 of 3 : UCIP_SP_2017_36168_65457.jpg

Concrete headwall, flap gate, and concrete apron located on waterward side.

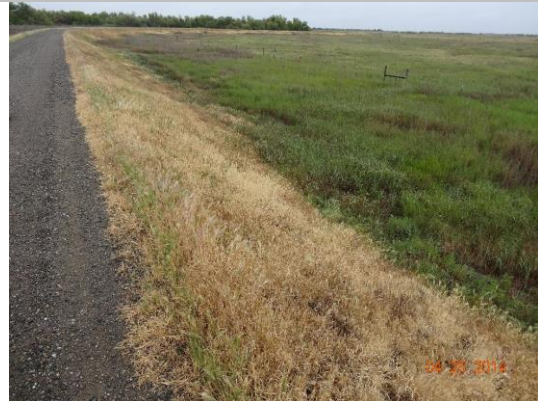
Photo 3 of 3 : UCIP_SP_2017_36168_65458.jpg

LM Start	15.29	Rating **	M	Issue No.	1242 (cont)	
LM End	15.29	Issue Type +	Ma	Location *	CR	
Category	Supplemental			GPS Latitude/Longitude		
				Start	End	
Item	DWR UCIP LMA Responsibility			37.231428 °	37.231428 °	
				-120.805543 °	-120.805543 °	
DWR ID						
Comment Code						
Inspector Comment						
FS_ID:36168 DS_ID:19643 EP_NO: N/A Repair Type: Non-Urgent Crossing Status: Found UCIP Comments: Dense vegetation limits the inspector's visibility to proper inspection of structure. FIELD_STRUCT_DESC: 24-inch CM pipe through the levee, 9.2 feet below the crown. Flap gate on the waterward end. Brass cap No. 60 BM on headwall on the landward side. (USACE-1967). This entry matches the Drainage or Irrigation Structure referenced in O&M manual (HLM 15.29). FS Date: 4/25/2014

View of landward side.

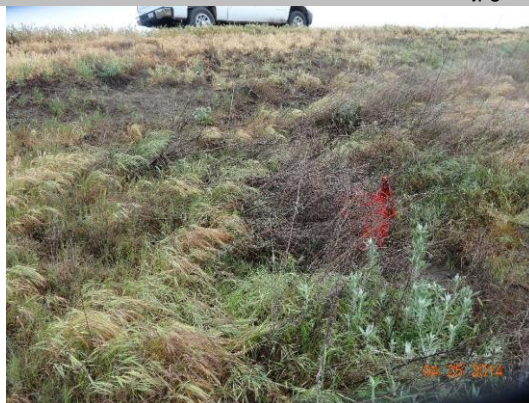
Photo 2 of 3 : UCIP_SP_2017_36169_65463.jpg

FS_ID:36169
DS_ID:19644
EP_NO: N/A
Repair Type: Non-Urgent
Crossing Status: Found
UCIP Comments: Dense vegetation limits the inspector's visibility to identify signs of pipe failure (leaks) along the waterward and landward slopes. Recommend removing vegetation along pipe alignment to conduct proper inspection of structure.
FIELD_STRUCT_DESC: 24-inch CM pipe through the levee, 8.5 feet below the crown. Flap gate on the waterward end. Brass cap No. 60 BM on headwall on the landward side. (USACE-1967). This entry matches the Drainage or Irrigation Structure referenced in O&M manual (HLM 15.57).
FS Date: 4/25/2014

View of waterward slope covered by dense vegetation.

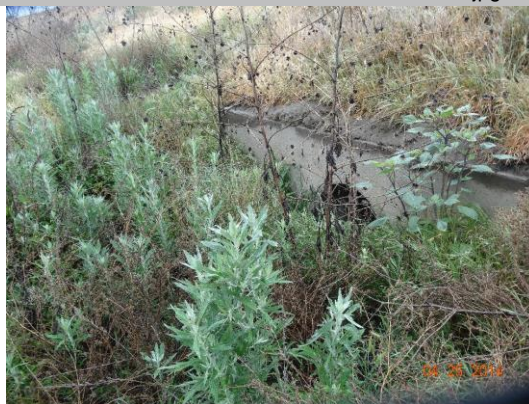
Photo 3 of 3 : UCIP_SP_2017_36169_65462.jpg

Concrete headwall visible on landward toe--dense vegetation blocking inlet.

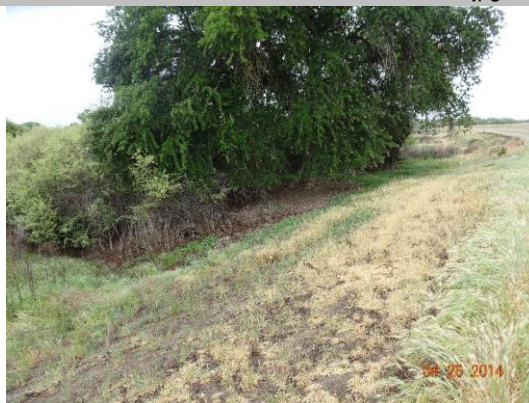
Photo 1 of 3 : UCIP_SP_2017_36171_65471.jpg

FS_ID:36171
DS_ID:19645
EP_NO: N/A
Repair Type: Non-Urgent
Crossing Status: Found
UCIP Comments: Dense vegetation limits the inspector's visibility to identify signs of pipe failure (leaks) along the waterward and landward slope. Recommend removing vegetation along pipe alignment to conduct proper inspection of structure.
FIELD_STRUCT_DESC: 24-inch CM pipe through the levee, 11.0 feet below the crown. Flap gate on the waterward end. Brass cap No. 60 BM on headwall on the landward side. (USACE-1967). This entry matches the Drainage or Irrigation Structure referenced in O&M manual (HLM 15.81).
FS Date: 4/25/2014

View of waterward side.

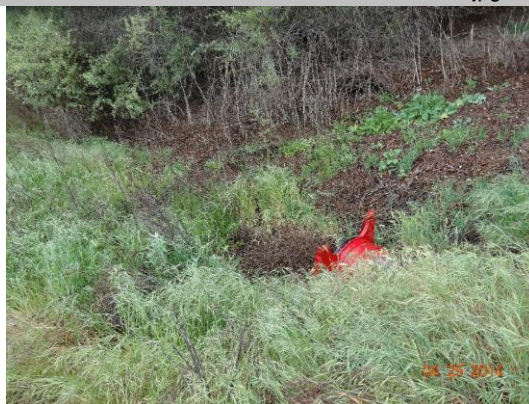
Photo 2 of 3 : UCIP_SP_2017_36171_65470.jpg

Flap gate visible on waterward side.

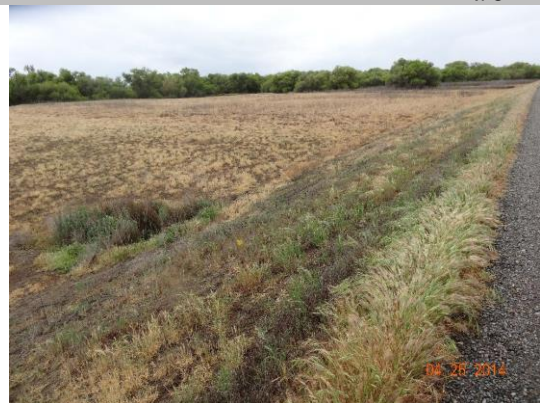
Photo 1 of 3 : UCIP_SP_2017_36172_65476.jpg

Comment Code					
Inspector Comment					
FS_ID:36172					
DS_ID:19646					
EP_NO: N/A					
Repair Type: Non-Urgent					
Crossing Status: Found					
UCIP Comments: Dense vegetation limits the inspector's visibility to identify signs of pipe failure (leaks) along the waterward and landward slopes. Recommend removing vegetation along pipe alignment to conduct proper inspection of structure and appurtenances.					
FIELD_STRUCT_DESC: 24-inch CM pipe through the levee, 11.3 feet below the crown. Flap gate on the waterward end. Brass cap No. 50 BM on headwall on the landward side. (USACE-1967). This entry matches the Drainage or Irrigation Structure referenced in O&M manual (HLM 16.09).					
FS Date: 4/25/2014

View of waterward side.

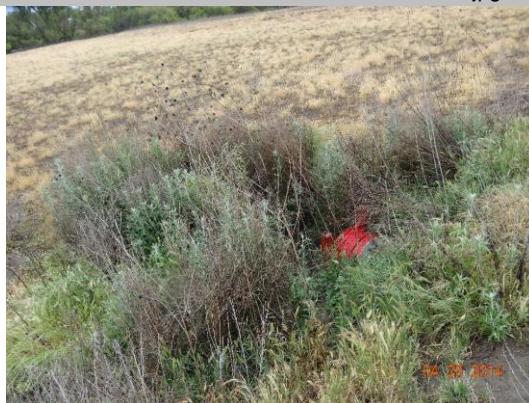
Photo 2 of 3 : UCIP_SP_2017_36172_65475.jpg

FS_ID:36172
DS_ID:19646
EP_NO: N/A
Repair Type: Non-Urgent
Crossing Status: Found
UCIP Comments: Dense vegetation limits the inspector's visibility to identify signs of pipe failure (leaks) along the waterward and landward slopes. Recommend removing vegetation along pipe alignment to conduct proper inspection of structure and appurtenances.
FIELD_STRUCT_DESC: 24-inch CM pipe through the levee, 11.3 feet below the crown. Flap gate on the waterward end. Brass cap No. 50 BM on headwall on the landward side. (USACE-1967). This entry matches the Drainage or Irrigation Structure referenced in O&M manual (HLM 16.09).
FS Date: 4/25/2014

Flap gate visible on waterward toe.

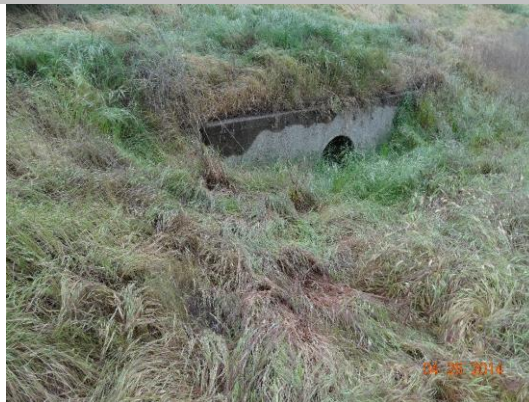
Photo 3 of 3 : UCIP_SP_2017_36172_65474.jpg

View of landward side.

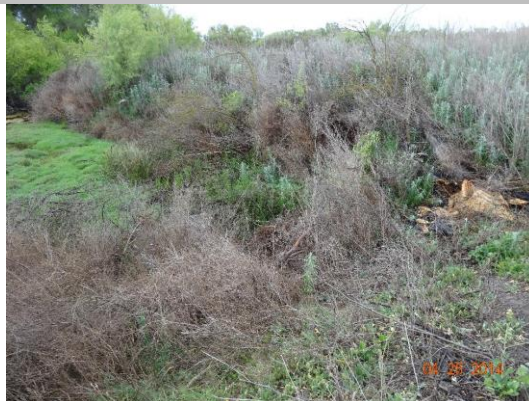
Photo 1 of 3 : UCIP_SP_2017_39257_65480.jpg

Comment Code					
Inspector Comment					
FS_ID:39257 DS_ID:19647 EP_NO: N/A Repair Type: Non-Urgent Crossing Status: Found UCIP Comments: Dense vegetation limits the inspector's visibility to identify signs of pipe failure (leaks) along the waterward and landward slopes. Recommend removing vegetation along pipe alignment to conduct proper inspection of structure. Unable to find pipe on landward side. FIELD_STRUCT_DESC: 24-inch CM pipe through the levee, 14.7 feet below the crown. Flap gate on the waterward end. Brass cap No. 50 BM on headwall on the landward side. (USACE-1967). This entry matches the Drainage or Irrigation Structure referenced in O&M manual (HLM 16.15). FS Date: 4/25/2014

View of waterward side.

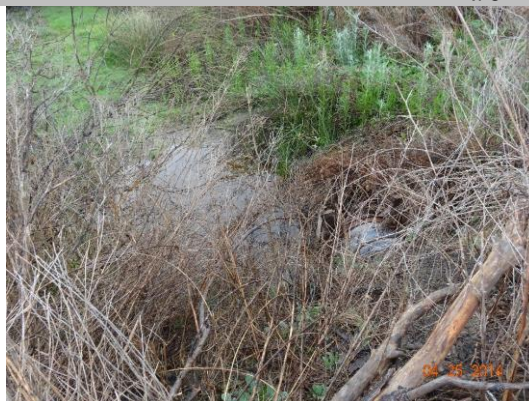
Photo 2 of 3 : UCIP_SP_2017_39257_65479.jpg

Crossing visible on waterward side under dense vegetation.

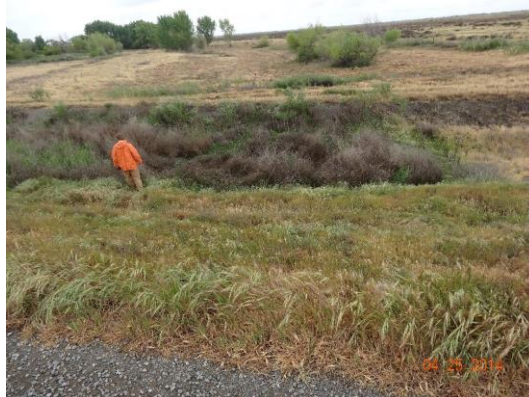
Photo 3 of 3 : UCIP_SP_2017_39257_65478.jpg

Item	DWR UCIP LMA Responsibility			37.224120 °	37.224120 °	
				-120.794002 °	-120.794002 °	
DWR ID						
Comment Code						
Inspector Comment						
FS_ID:39257						
DS_ID:19647						
EP_NO: N/A						
Repair Type: Non-Urgent						
Crossing Status: Found						
UCIP Comments: Dense vegetation limits the inspector's visibility to identify signs of pipe failure (leaks) along the waterward and landward slopes. Recommend removing vegetation along pipe alignment to conduct proper inspection of structure. Unable to find pipe on landward side.						
FIELD_STRUCT_DESC: 24-inch CM pipe through the levee, 14.7 feet below the crown. Flap gate on the waterward end. Brass cap No. 50 BM on headwall on the landward side. (USACE-1967). This entry matches the Drainage or Irrigation Structure referenced in O&M manual (HLM 16.15).						
FS Date: 4/25/2014

View of landward side.

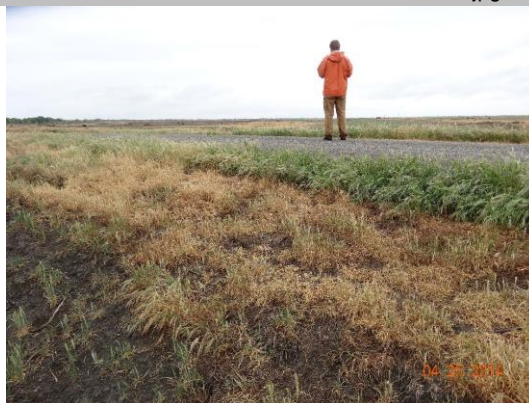
Photo 1 of 3 : UCIP_SP_2017_39258_66288.jpg

Comment Code					
Inspector Comment					
FS_ID:39258 DS_ID:19648 EP_NO: N/A Repair Type: Non-Urgent Crossing Status: Found UCIP Comments: Dense vegetation limits the inspector's visibility to identify signs of pipe failure (leaks) along the waterward and landward slopes. Recommend removing vegetation along pipe alignment to conduct proper inspection of structure. Unable to find pipe on landward side. FIELD_STRUCT_DESC: 24-inch CM pipe through the levee, 11.4 feet below the crown. Flap gate on the waterward end. Brass cap No. 50 BM on headwall on the landward side. (USACE-1967). This entry matches the Drainage or Irrigation Structure referenced in O&M manual (HLM 16.72). FS Date: 4/25/2014

View of levee crown at crossing.

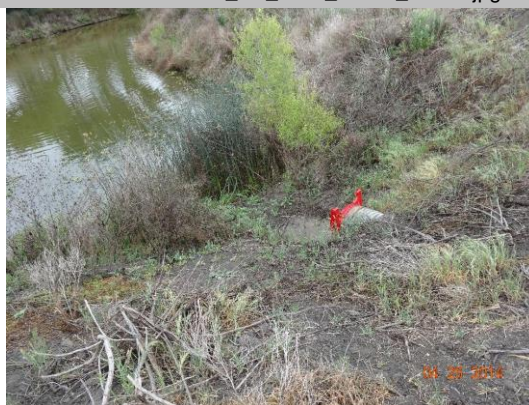
Photo 2 of 3 : UCIP_SP_2017_39258_66289.jpg

View of waterward side.

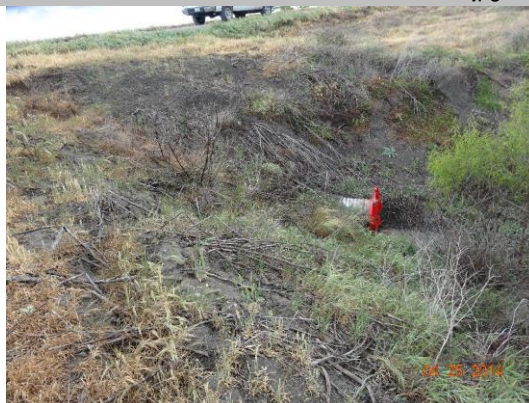
Photo 3 of 3 : UCIP_SP_2017_39258_66287.jpg

Item	DWR UCIP LMA Responsibility			37.224223 °	37.224223 °	
				-120.783806 °	-120.783806 °	
DWR ID						
Comment Code						
Inspector Comment						
FS_ID:39258 DS_ID:19648 EP_NO: N/A Repair Type: Non-Urgent Crossing Status: Found UCIP Comments: Dense vegetation limits the inspector's visibility to identify signs of pipe failure (leaks) along the waterward and landward slopes. Recommend removing vegetation along pipe alignment to conduct proper inspection of structure. Unable to find pipe on landward side. FIELD_STRUCT_DESC: 24-inch CM pipe through the levee, 11.4 feet below the crown. Flap gate on the waterward end. Brass cap No. 50 BM on headwall on the landward side. (USACE-1967). This entry matches the Drainage or Irrigation Structure referenced in O&M manual (HLM 16.72). FS Date: 4/25/2014

View of flap gate visible on waterward side.

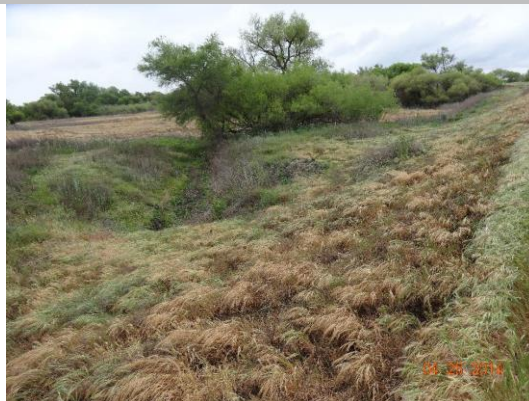
Photo 1 of 3 : UCIP_SP_2017_39259_65518.jpg

FS_ID:39259
DS_ID:19577
EP_NO: N/A
Repair Type: Non-Urgent
Crossing Status: Found
UCIP Comments: Dense vegetation limits the inspector's visibility to identify signs of pipe failure (leaks) along the waterward and landward slopes. Concrete headwall is buried by dense vegetation. Recommend removing vegetation along pipe alignment to conduct proper inspection of structure.
FIELD_STRUCT_DESC: 24-inch CM pipe through the levee, 11.5 feet below the crown. Flap gate on the waterward end. Brass cap No. 50 BM on headwall on the landward side. (USACE-1967). This entry matches the Drainage or Irrigation Structure referenced in O&M manual (HLM 17.01).
FS Date: 4/25/2014

View of waterward side.

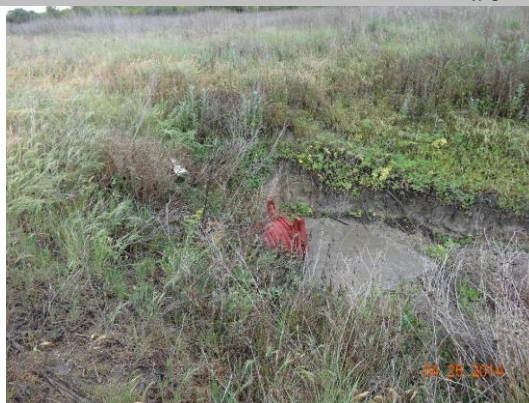
Photo 2 of 3 : UCIP_SP_2017_39259_65519.jpg

Flap gate visible on waterward side.

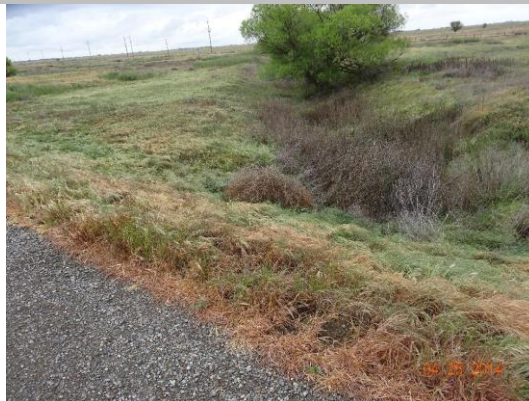
Photo 3 of 3 : UCIP_SP_2017_39259_65517.jpg

Item	DWR UCIP LMA Responsibility			37.221838 °	37.221838 °	
				-120.780230 °	-120.780230 °	
DWR ID						
Comment Code						
Inspector Comment						
FS_ID:39259						
DS_ID:19577						
EP_NO: N/A						
Repair Type: Non-Urgent						
Crossing Status: Found						
UCIP Comments: Dense vegetation limits the inspector's visibility to identify signs of pipe failure (leaks) along the waterward and landward slopes. Concrete headwall is buried by dense vegetation. Recommend removing vegetation along pipe alignment to conduct proper inspection of structure.						
FIELD_STRUCT_DESC: 24-inch CM pipe through the levee, 11.5 feet below the crown. Flap gate on the waterward end. Brass cap No. 50 BM on headwall on the landward side. (USACE-1967). This entry matches the Drainage or Irrigation Structure referenced in O&M manual (HLM 17.01).						
FS Date: 4/25/2014

View of landward side.

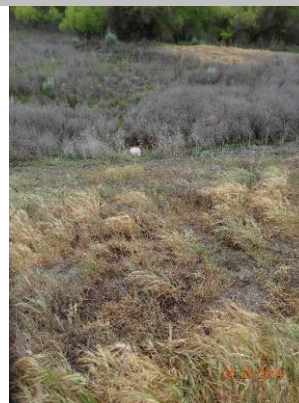
Photo 1 of 3 : UCIP_SP_2017_39260_65525.jpg

Comment Code					
Inspector Comment					
FS_ID:39260 DS_ID:19578 EP_NO: N/A Repair Type: Non-Urgent Crossing Status: Found UCIP Comments: Dense vegetation limits the inspector's visibility to identify signs of pipe failure (leaks) along the waterward and landward slopes. Recommend removing vegetation along pipe alignment to conduct proper inspection of structure. Sediment buildup inside pipe visible from landward side. Recommend clearing pipe. FIELD_STRUCT_DESC: 24-inch CM pipe through the levee, 11.5 feet below the crown. Flap gate on the waterward end. Brass cap No. 50 BM on headwall on the landward side. (USACE-1967). This entry matches the Drainage or Irrigation Structure referenced in O&M manual (HLM 17.19). FS Date: 4/25/2014

View of waterward side.

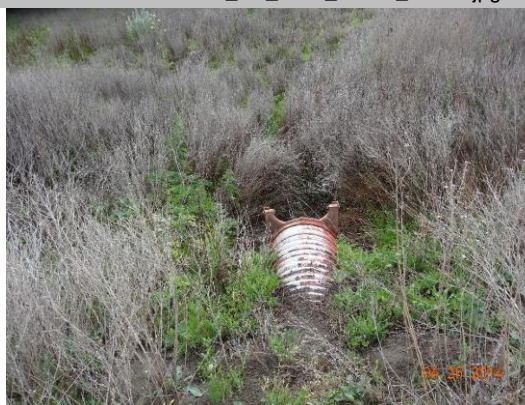
Photo 2 of 3 : UCIP_SP_2017_39260_65521.jpg

Pipe visible on waterward side.

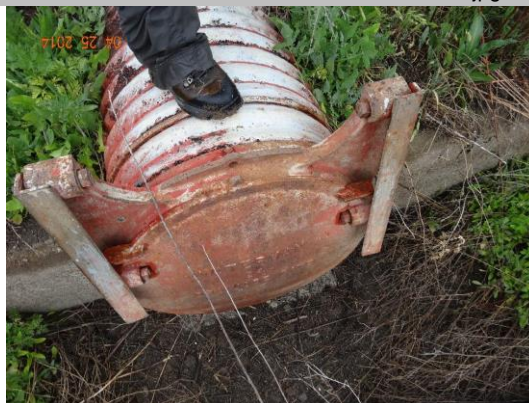
Photo 3 of 3 : UCIP_SP_2017_39260_65520.jpg

Item	DWR UCIP LMA Responsibility			37.219302 °	37.219302 °	
				-120.779475 °	-120.779475 °	
DWR ID						
Comment Code						
Inspector Comment						
FS_ID:39260						
DS_ID:19578						
EP_NO: N/A						
Repair Type: Non-Urgent						
Crossing Status: Found						
UCIP Comments: Dense vegetation limits the inspector's visibility to identifying signs of pipe failure (leaks) along the waterward and landward slopes. Recommend removing vegetation along pipe alignment to conduct proper inspection of structure. Sediment buildup inside pipe visible from landward side. Recommend clearing pipe.						
FIELD_STRUCT_DESC: 24-inch CM pipe through the levee, 11.5 feet below the crown. Flap gate on the waterward end. Brass cap No. 50 BM on headwall on the landward side. (USACE-1967). This entry matches the Drainage or Irrigation Structure referenced in O&M manual (HLM 17.19).						
FS Date: 4/25/2014

Flap gate visible on waterward toe.

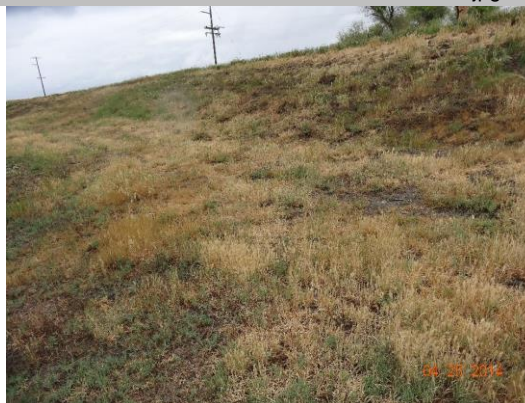
Photo 1 of 3 : UCIP_SP_2017_36203_65551.jpg

FS_ID:36203
 DS_ID:19579
 EP_NO: N/A
 Repair Type: Non-Urgent
 Crossing Status: Found
 UCIP Comments: Dense vegetation limits the inspector's visibility to identify signs of pipe failure (leaks) along the waterward and landward slope. Recommend removing vegetation along pipe alignment to conduct proper inspection of structure.
 FIELD_STRUCT_DESC: 24-inch CM pipe through the levee, 15.8 feet below the crown. Flap gate on the waterward end. Brass cap No. 50 BM on headwall on the landward side. (USACE-1967). This entry matches the Drainage or Irrigation Structure referenced in O&M manual (HLM 17.26).
 FS Date: 4/25/2014

View of waterward slope.

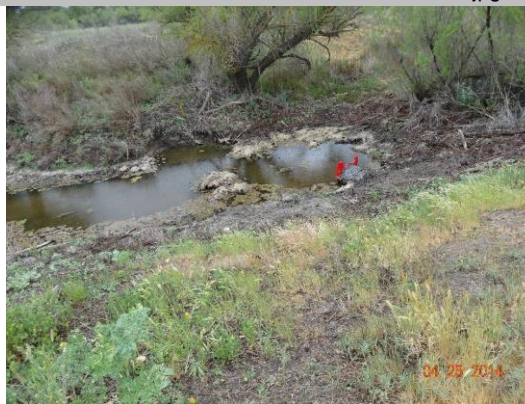
Photo 2 of 3 : UCIP_SP_2017_36203_65552.jpg

Pipe visible on waterward side.

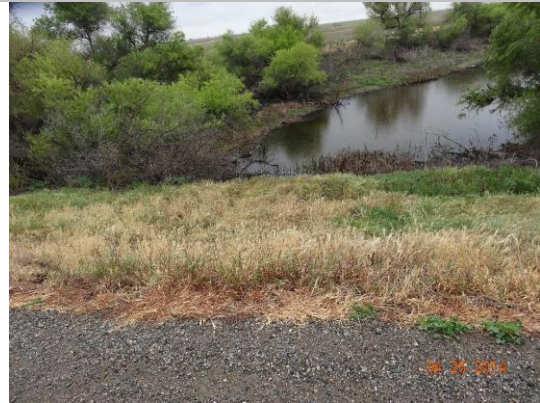
Photo 3 of 3 : UCIP_SP_2017_36203_65554.jpg

Item	DWR UCIP LMA Responsibility			37.218332 °	37.218332 °	
				-120.779459 °	-120.779459 °	
DWR ID						
Comment Code						
Inspector Comment						
FS_ID:36203 DS_ID:19579 EP_NO: N/A Repair Type: Non-Urgent Crossing Status: Found UCIP Comments: Dense vegetation limits the inspector's visibility to identify signs of pipe failure (leaks) along the waterward and landward slope. Recommend removing vegetation along pipe alignment to conduct proper inspection of structure. FIELD_STRUCT_DESC: 24-inch CM pipe through the levee, 15.8 feet below the crown. Flap gate on the waterward end. Brass cap No. 50 BM on headwall on the landward side. (USACE-1967). This entry matches the Drainage or Irrigation Structure referenced in O&M manual (HLM 17.26). FS Date: 4/25/2014

View of landward side.

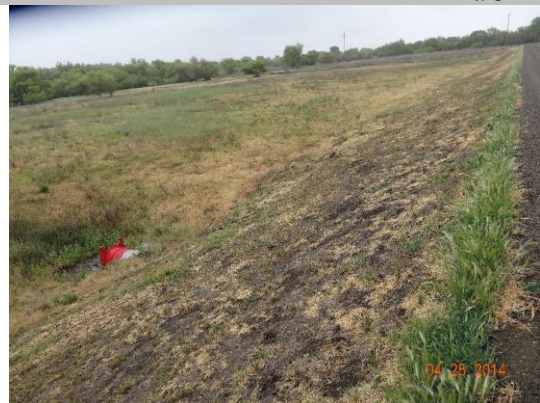
Photo 1 of 3 : UCIP_SP_2017_36204_65547.jpg

LM Start	17.52	Rating **	M	Issue No.	1252
LM End	17.52	Issue Type +	Ma	Location *	CR
Category	Supplemental			GPS Latitude/Longitude	
				Start	End
Item	DWR UCIP LMA Responsibility			37.215976 °	37.215976 °
				-120.777615 °	-120.777615 °
DWR ID					
Comment Code					
Inspector Comment					
FS_ID:36204 DS_ID:19580 EP_NO: N/A Repair Type: Non-Urgent Crossing Status: Found UCIP Comments: Dense vegetation limits the inspector's visibility to identify signs of pipe failure (leaks) along the landward slope. Recommend removing vegetation along pipe alignment to conduct proper inspection of structure. FIELD_STRUCT_DESC: 24-inch CM pipe through the levee, 9.5 feet below the crown. Flap gate on the waterward end. Brass cap No. 50 BM on headwall on the landward side. (USACE-1967). This entry matches the Drainage or Irrigation Structure referenced in O&M manual (HLM 17.53). FS Date: 4/25/2014

View of waterward side.

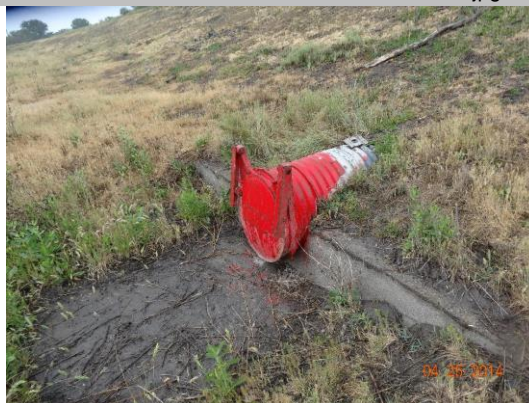
Photo 2 of 3 : UCIP_SP_2017_36204_65546.jpg

Comment Code					
Inspector Comment					
FS_ID:36204 DS_ID:19580 EP_NO: N/A Repair Type: Non-Urgent Crossing Status: Found UCIP Comments: Dense vegetation limits the inspector's visibility to identify signs of pipe failure (leaks) along the landward slope. Recommend removing vegetation along pipe alignment to conduct proper inspection of structure. FIELD_STRUCT_DESC: 24-inch CM pipe through the levee, 9.5 feet below the crown. Flap gate on the waterward end. Brass cap No. 50 BM on headwall on the landward side. (USACE-1967). This entry matches the Drainage or Irrigation Structure referenced in O&M manual (HLM 17.53). FS Date: 4/25/2014

Flap gate visible on waterward side.

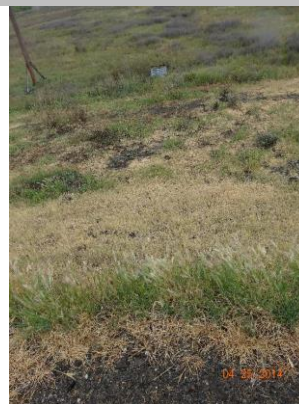
Photo 3 of 3 : UCIP_SP_2017_36204_65545.jpg

View of landward side--riser at levee toe.

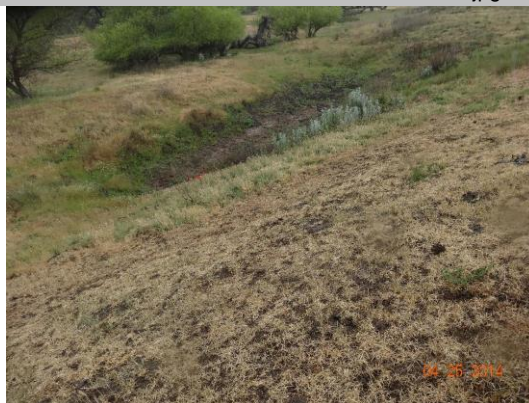
Photo 1 of 3 : UCIP_SP_2017_39261_65557.jpg

LM Start	18.18	Rating **	M	Issue No.	1253
LM End	18.18	Issue Type +	Ma	Location *	CR
Category	Supplemental			GPS Latitude/Longitude	
				Start	End
Item	DWR UCIP LMA Responsibility			37.210998 °	37.210998 °
				-120.768900 °	-120.768900 °
DWR ID					
Comment Code					
Inspector Comment					
FS_ID:39261 DS_ID:19581 EP_NO: N/A Repair Type: Non-Urgent Crossing Status: Found UCIP Comments: Need to contact owner. Recommend investigating integrity of pipe wall through levee heavy corrosion visible from landward side. FIELD_STRUCT_DESC: 24-inch CM pipe through the levee, 11.5 feet below the crown. Flap gate on the waterward end. Brass cap No. 50 BM on headwall on the landward side. (USACE-1967). This entry matches the Drainage or Irrigation Structure referenced in O&M manual (HLM 18.19). FS Date: 4/25/2014

View of waterward side.

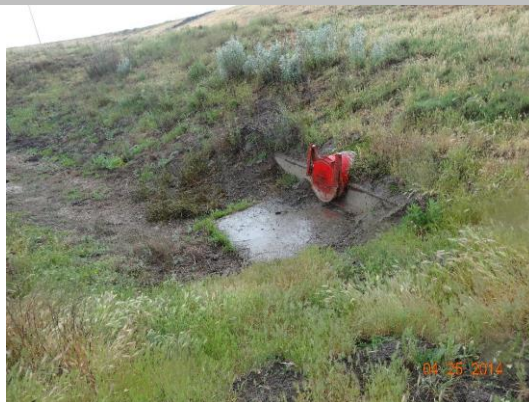
Photo 2 of 3 : UCIP_SP_2017_39261_65556.jpg

Flap gate visible on waterward side.

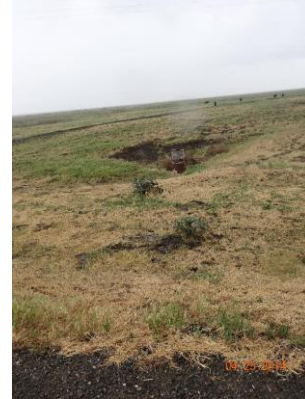
Photo 3 of 3 : UCIP_SP_2017_39261_65555.jpg

View of landward side.

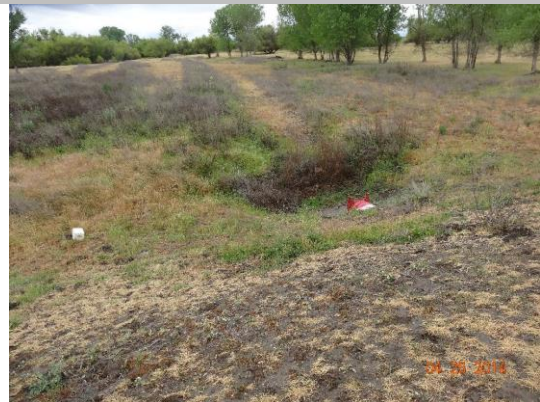
Photo 1 of 3 : UCIP_SP_2017_36206_65563.jpg

LM Start	18.45	Rating **	A/W	Issue No.	1254
LM End	18.45	Issue Type +	Ma	Location *	CR
Category	Supplemental			GPS Latitude/Longitude	
				Start	End
Item	DWR UCIP LMA Responsibility			37.207538 °	37.207538 °
				-120.767679 °	-120.767679 °
DWR ID					
Comment Code					
Inspector Comment					
FS_ID:36206					
DS_ID:19582					
EP_NO: N/A					
Repair Type: No Action Needed					
Crossing Status: Found					
UCIP Comments:					
FIELD_STRUCT_DESC: 24-inch CM pipe through the levee, 9.4 feet below the crown. Flap gate on the waterward end. Brass cap No. 50 BM on headwall on the landward side. (USACE-1967). This entry matches the Drainage or Irrigation Structure referenced in O&M manual (HLM 18.45).					
FS Date: 4/25/2014

View of waterward side.

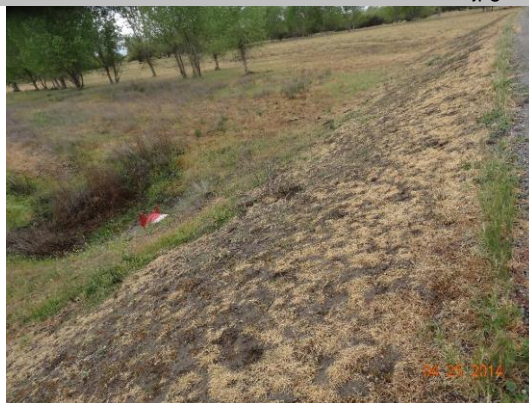
Photo 2 of 3 : UCIP_SP_2017_36206_65562.jpg

View of waterward slope.

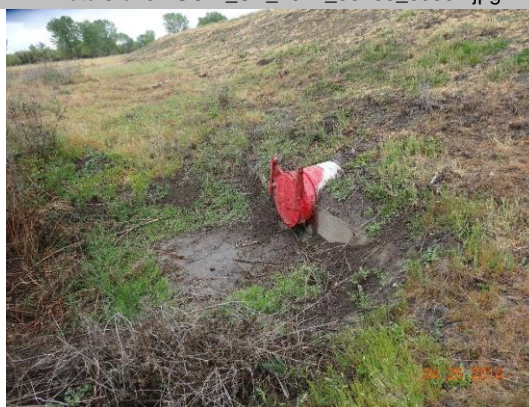
Photo 3 of 3 : UCIP_SP_2017_36206_65561.jpg

Flap gate visible on waterward side.

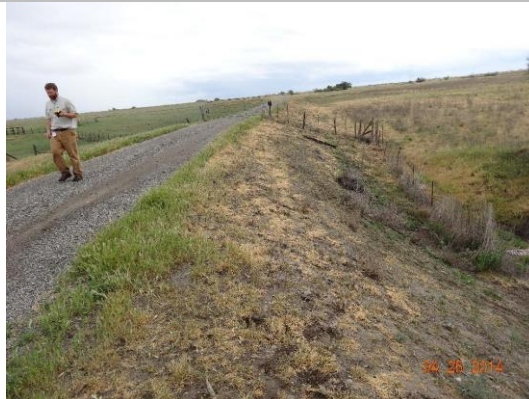
Photo 1 of 3 : UCIP_SP_2017_36246_65627.jpg

FS_ID:36246
DS_ID:19593
EP_NO: N/A
Repair Type: Non-Urgent
Crossing Status: Found
UCIP Comments: Dense vegetation limits the inspector's visibility to identify signs of pipe failure (leaks) along the landward slope. Recommend removing vegetation along pipe alignment to conduct proper inspection of structure.
FIELD_STRUCT_DESC: 24-inch CM pipe through the levee, 12.0 feet below the crown. Flap gate on the waterward end. Brass cap No. 50 BM on headwall on the landward side. (USACE-1967). This entry matches the Drainage or Irrigation Structure referenced in O&M manual (HLM 18.79).
FS Date: 4/25/2014

Overview of levee crown and waterward slope.

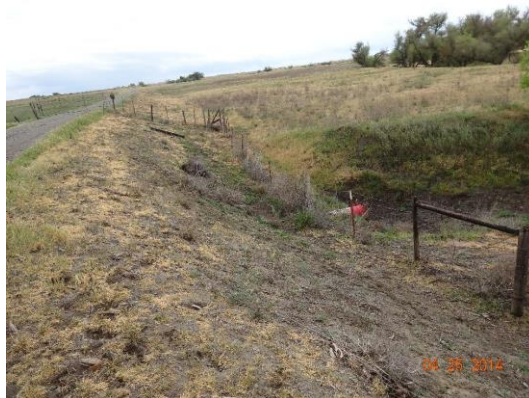
Photo 2 of 3 : UCIP_SP_2017_36246_65623.jpg

View of waterward side.

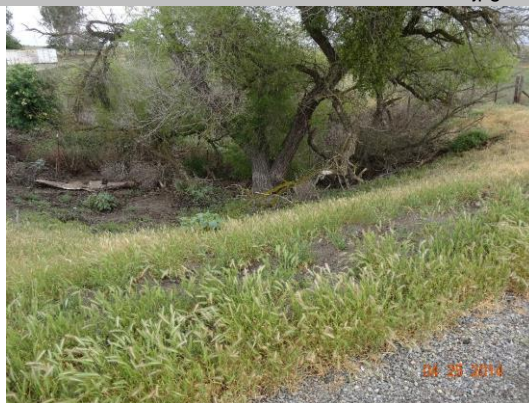
Photo 3 of 3 : UCIP_SP_2017_36246_65626.jpg

Overview of landward side.

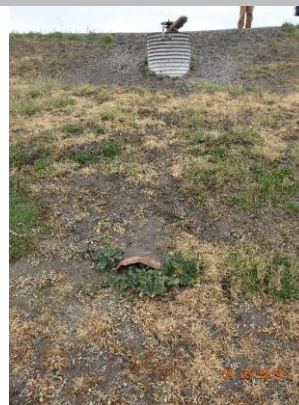
Photo 1 of 3 : UCIP_SP_2017_39263_65631.jpg

Comment Code					
Inspector Comment					
FS_ID:39263 DS_ID:19594 EP_NO: N/A Repair Type: Non-Urgent Crossing Status: Found UCIP Comments: Non-functional crossing--pipe is buried on waterward side. Sediment buildup in pipe visible from landward side. Need to coordinate with owner to determine status. If crossing is no longer in use, owner will need to coordinate with DWR Inspector and CVFPB to properly abandon. FIELD_STRUCT_DESC: 24-inch CM pipe through the levee, 13.0 feet below the crown. Slide gate on the waterward slope. Brass cap No. 40 BM on headwall on the landward side. (USACE-1967). This entry matches the Drainage or Irrigation Structure referenced in O&M manual (HLM 19.17). FS Date: 4/25/2014

View of waterward slope. CMP riser and pipe visible.

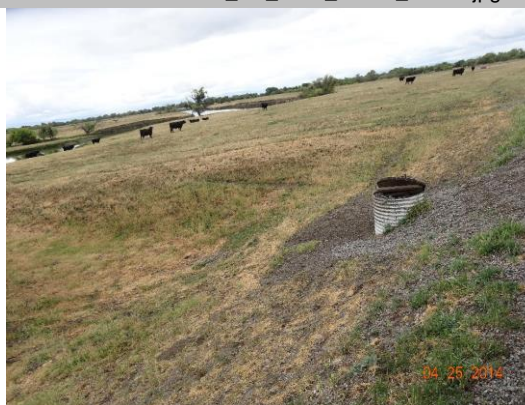
Photo 2 of 3 : UCIP_SP_2017_39263_65630.jpg

View of waterward side.

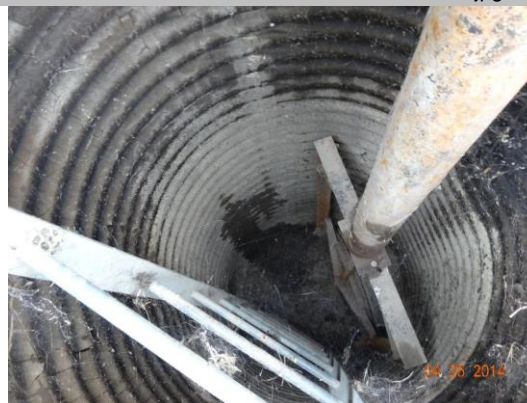
Photo 3 of 3 : UCIP_SP_2017_39263_65632.jpg

Inside view of CMP riser.

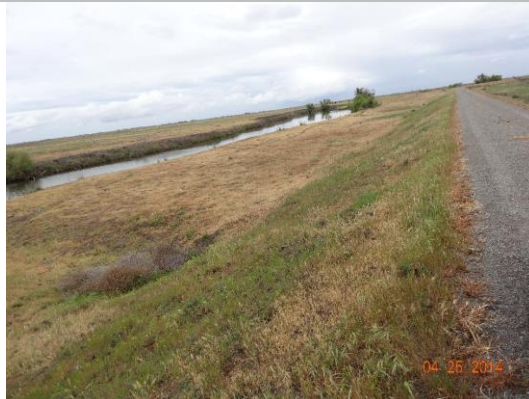
Photo 1 of 3 : UCIP_SP_2017_39268_65641.jpg

FS_ID:39268
DS_ID:19596
EP_NO: N/A
Repair Type: Non-Urgent
Crossing Status: Found
UCIP Comments: Dense vegetation limits the inspector's visibility to identify signs of pipe failure (leaks) along the waterward slope. Recommend removing vegetation along pipe alignment to conduct proper inspection of structure. Dense vegetation blocks both waterward and landward headwalls. Sediment buildup in pipe visible from landward side.
FIELD_STRUCT_DESC: 24-inch CM pipe through the levee, 8.0 feet below the crown. Flap gate on the waterward end. Brass cap No. 40 BM on headwall on the landward side. (USACE-1967). This entry matches the Drainage or Irrigation Structure referenced in O&M manual (HLM 19.54).
FS Date: 4/25/2014

View of waterward side.

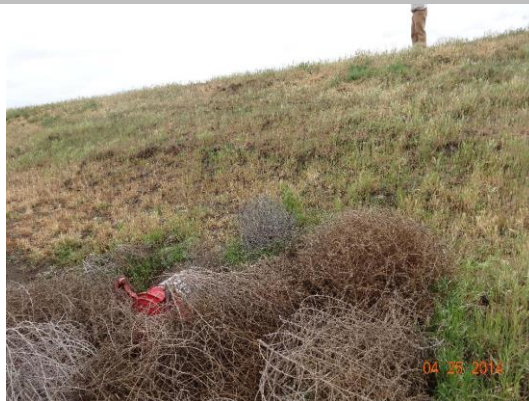
Photo 2 of 3 : UCIP_SP_2017_39268_65640.jpg

Flap gate visible on waterward side--potential erosion present on slope.

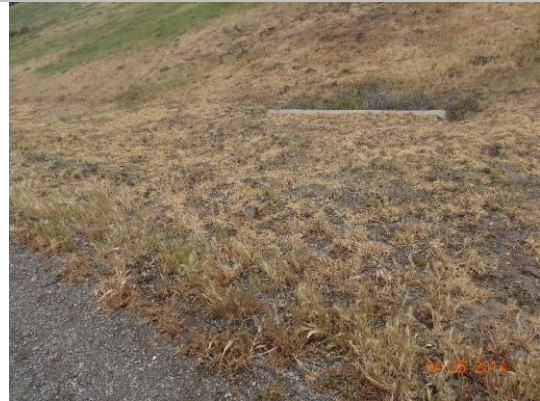
Photo 3 of 3 : UCIP_SP_2017_39268_65639.jpg

View of landward slope.

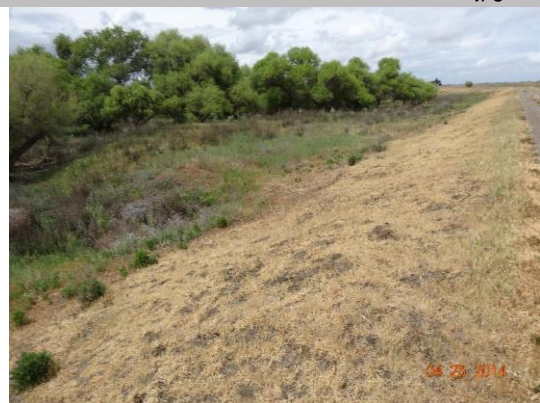
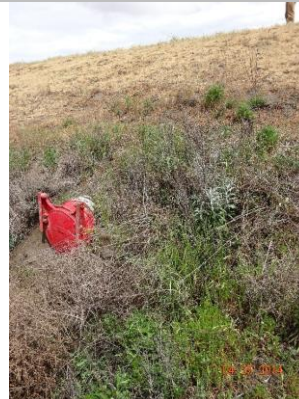
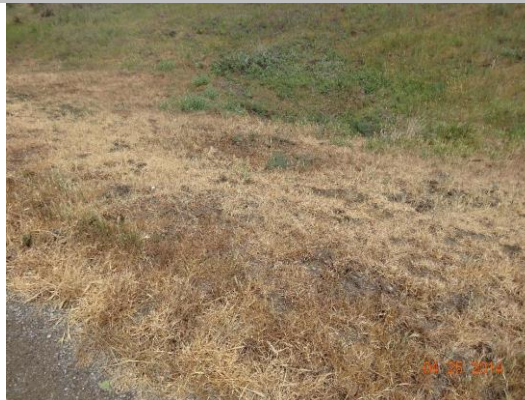
LM Start	20.18	Rating **	M	Issue No.	1261
LM End	20.18	Issue Type +	Ma	Location *	CR
Category	Supplemental			GPS Latitude/Longitude	
				Start	End
Item	DWR UCIP LMA Responsibility			37.194669 °	37.194669 °
				-120.759736 °	-120.759736 °
DWR ID					
Comment Code					
Inspector Comment					
FS_ID:39269 DS_ID:19598 EP_NO: N/A Repair Type: Non-Urgent Crossing Status: Found UCIP Comments: Recommend removing vegetation and sediment buildup from both waterward and landward concrete headwalls. FIELD_STRUCT_DESC: 24-inch CM pipe through the levee, 8.5 feet below the crown. Flap gate on the waterward end. Brass cap No. 40 BM on headwall on the landward side. (USACE-1967). This entry matches the Drainage or Irrigation Structure referenced in O&M manual (HLM 20.18). FS Date: 4/25/2014

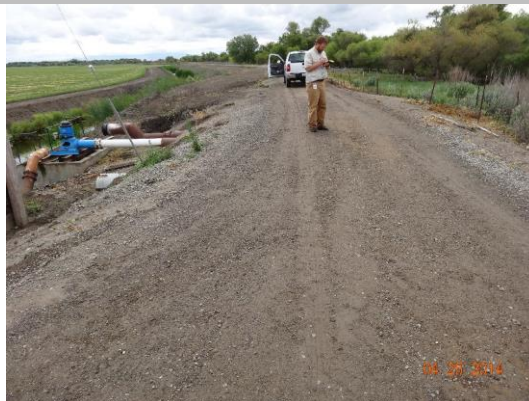
Photo 1 of 3 : UCIP_SP_2017_39878_66308.jpg

FS_ID:39878
DS_ID:19600
EP_NO: N/A
Repair Type: Non-Urgent
Crossing Status: Found
UCIP Comments: Crossing partially submersed--no signs of failure of pipe present along pipe alignment. Recommend contacting owner to determine status of crossing and condition.
FIELD_STRUCT_DESC: 36-inch CM pipe through the levee, 10.5 feet below the crown. Flap gate on the waterward end. Brass cap No. 40 BM on headwall on the landward side. (USACE-1967). This entry matches the Drainage or Irrigation Structure referenced in O&M manual (HLM 20.27).
FS Date: 4/25/2014

Overview of levee crown at crossing--multiple crossings at this location.

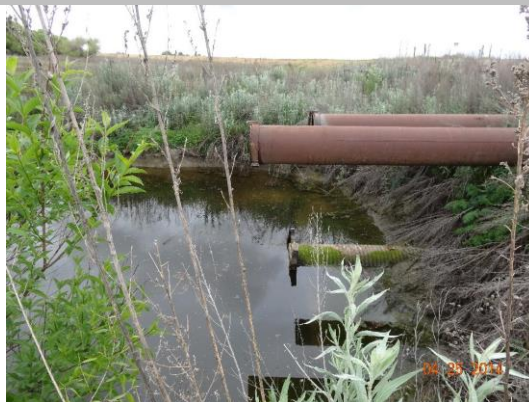
Photo 2 of 3 : UCIP_SP_2017_39878_66309.jpg

Multiple crossings visible on waterward side--36 inch CMP is submersed in water.

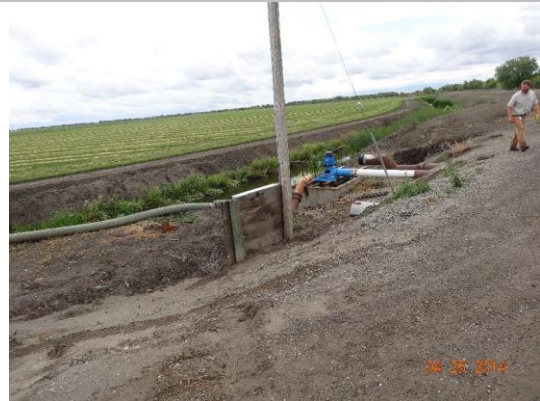
Photo 3 of 3 : UCIP_SP_2017_39878_66307.jpg

View of landward side.

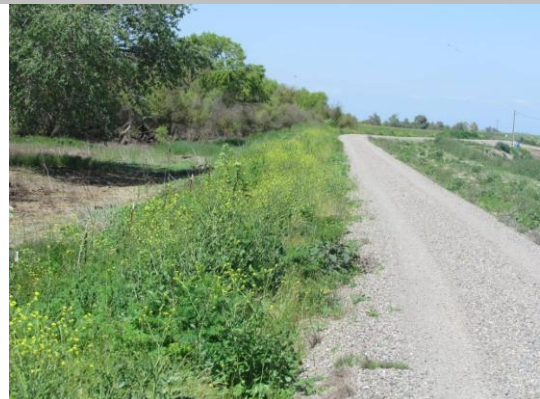
Photo 1 of 1 : SP_2017_NA0010_118_8_20170424_00281.jpg

LM Start	20.44	Rating **	U	Issue No.	8
LM End	22.46	Issue Type +	Ma	Location *	WS
Category	Earthen Levee			GPS Latitude/Longitude	
				Start	End
Item	Vegetation			37.191348 °	37.167498 °
				-120.761802 °	-120.750862 °
DWR ID	DWR_NA0010_01_f_2015_8				
Comment Code					
V2 : Remove the wild growth other than native grasses from the levee slopes.					
Inspector Comment					
Dense vegetation on waterward slope.

Looking downstream at dense veg on waterward slope.

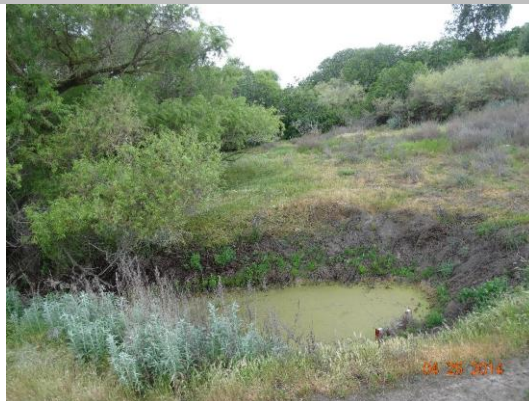
Photo 1 of 3 : UCIP_SP_2017_39271_66312.jpg

FS_ID:39271
DS_ID:19603
EP_NO: N/A
Repair Type: Non-Urgent
Crossing Status: Found
UCIP Comments: Crossing is non-functional--crossing buried on landward side. Need to contact owner to determine status of crossing. If crossing is no longer used need to coordinate with CVFPB for proper abandonment.
FIELD_STRUCT_DESC: 36-inch CM pipe through the levee, 11.5 feet below the crown. Flap gate on the waterward end. Brass cap No. 40 BM on headwall on the landward side. (USACE-1967). This entry matches the Drainage or Irrigation Structure referenced in O&M manual (HLM 21.40).
FS Date: 4/25/2014

View of waterward side.

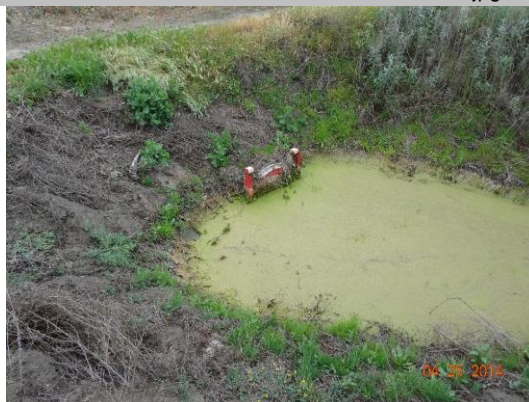
Photo 2 of 3 : UCIP_SP_2017_39271_66313.jpg

Flap gate half way submersed located on waterward side.

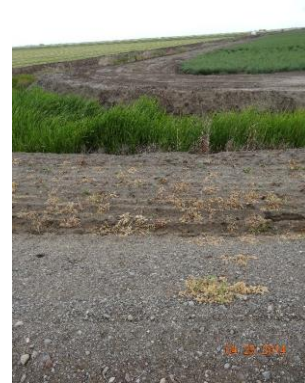
Photo 3 of 3 : UCIP_SP_2017_39271_66311.jpg

Item	DWR UCIP LMA Responsibility			37.179065 °		37.179065 °
				-120.761567 °		-120.761567 °
DWR ID						
Comment Code						
Inspector Comment						
FS_ID:39271 DS_ID:19603 EP_NO: N/A Repair Type: Non-Urgent Crossing Status: Found UCIP Comments: Crossing is non-functional--crossing buried on landward side. Need to contact owner to determine status of crossing. If crossing is no longer used need to coordinate with CVFPB for proper abandonment. FIELD_STRUCT_DESC: 36-inch CM pipe through the levee, 11.5 feet below the crown. Flap gate on the waterward end. Brass cap No. 40 BM on headwall on the landward side. (USACE-1967). This entry matches the Drainage or Irrigation Structure referenced in O&M manual (HLM 21.40). FS Date: 4/25/2014

View of landward side.

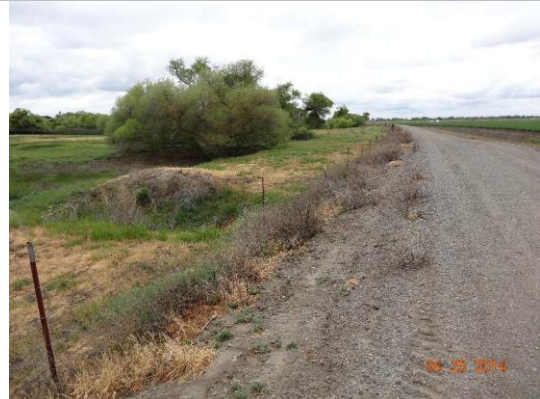
Photo 1 of 3 : UCIP_SP_2017_39272_65697.jpg

Comment Code					
Inspector Comment					
FS_ID:39272					
DS_ID:19604					
EP_NO: N/A					
Repair Type: Non-Urgent					
Crossing Status: Found					
UCIP Comments: Non-functional crossing-landward side is buried.					
Need to contact owner to determine status of crossing. If crossing is no					
longer used need to coordinate with CVFPB for proper abandonment.					
FIELD_STRUCT_DESC: 24-inch CM pipe through the levee, 9.0 feet					
below the crown. Flap gate on the waterward end. Brass cap No. 40 BM					
on headwall on the landward side. (USACE-1967). This entry matches					
the Drainage or Irrigation Structure referenced in O&M manual (HLM

View of waterward side.

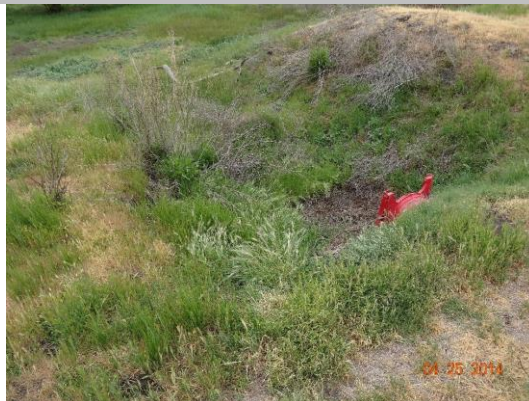
Photo 2 of 3 : UCIP_SP_2017_39272_65695.jpg

Flap gate visible on waterward side.

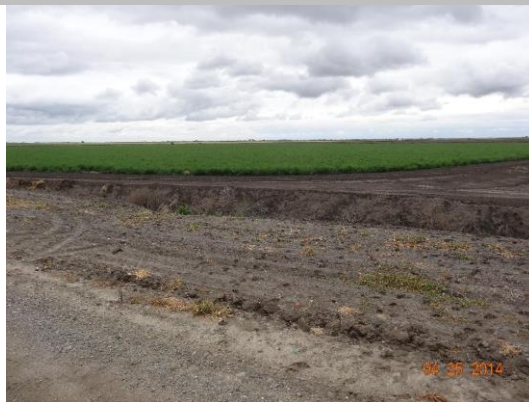
Photo 3 of 3 : UCIP_SP_2017_39272_65696.jpg

View of landward side.

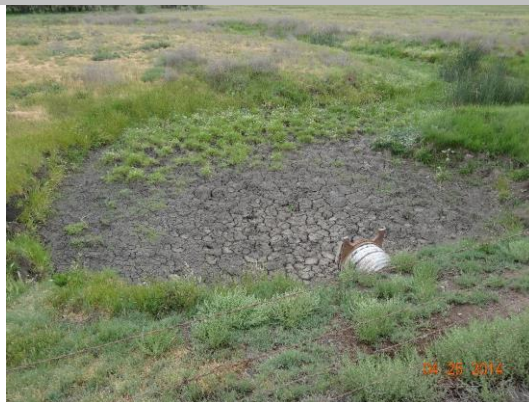
Photo 2 of 3 : UCIP_SP_2017_39273_65707.jpg

Flap gate visible on waterward side.

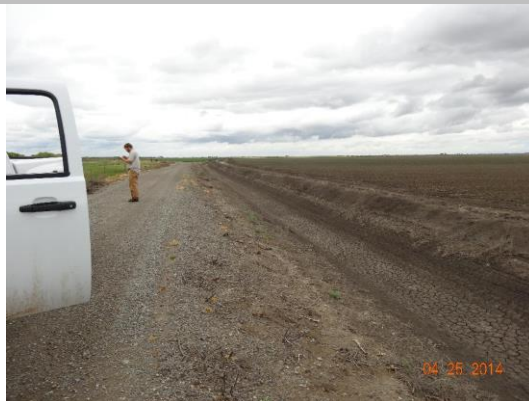
Photo 3 of 3 : UCIP_SP_2017_39273_65708.jpg

Item	DWR UCIP LMA Responsibility			37.171181 °		37.171181 °
				-120.754526 °		-120.754526 °
DWR ID						
Comment Code						
Inspector Comment						
FS_ID:39273 DS_ID:19605 EP_NO: N/A Repair Type: Non-Urgent Crossing Status: Found UCIP Comments: Non-functional crossing--landward side is buried. Need to contact owner to determine status. If crossing is no longer used need to coordinate with CVFPB for proper abandonment. FIELD_STRUCT_DESC: 24-inch CM pipe through the levee, 9.0 feet below the crown. Flap gate on the waterward end. Wooden head- boards on the landward end of pipe. Brass cap No. 31 BM on headwall on the landward side. (USACE-1967). This entry matches the Drainage or Irrigation Structure referenced in O&M manual (HLM 22.13). FS Date: 4/25/2014

View of landward side.

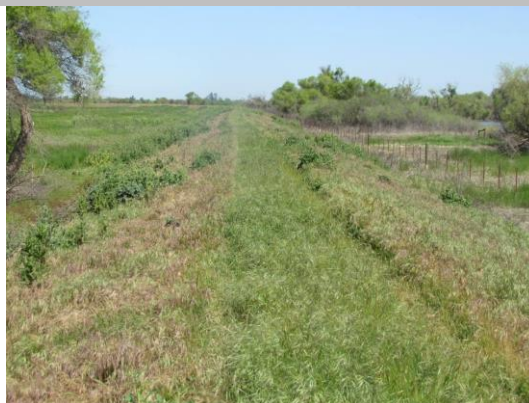
Photo 1 of 1 : SP_2017_NA0010_119_23_20170424_00071.jpg

LM Start	0.00	Rating **	M	Issue No.	23
LM End	0.69	Issue Type +	Ma	Location *	CR
Category	Earthen Levee			GPS Latitude/Longitude	
				Start	End
Item	Crown Surface / Depressions / Rutting			37.296318 °	37.287788 °
				-120.880600 °	-120.874720 °
DWR ID	DWR_NA0010_02A_s_2017_23				
Comment Code					
C3 : Add appropriate gravel or road base. Grade and compact.					
Inspector Comment					
Levee crown is over grown.

Looking downstream at overgrown levee crown.
