**Flood Control Project Maintenance
Levee Inspections**

Maintenance Issue Types Only, Levee Inspection Report By Mile - Spring 2017

Lower San Joaquin Levee District

Waterway	Bank	Unit Miles	Inspection Start/End	Inspector
Unit No. 01 San Joaquin River	Right	22.52	04/17/2017 04/20/2017	Richard Willoughby

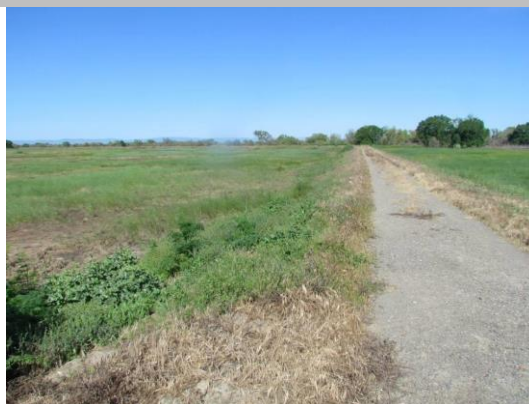
Photo 1 of 1 : SP_2017_NA0010_119_27_20170424_00072.jpg

LM Start	0.00	Rating **	M	Issue No.	27
LM End	7.86	Issue Type +	Ma	Location *	LS
Category	Earthen Levee			GPS Latitude/Longitude	
				Start	End
Item	Vegetation			37.296305 °	37.231303 °
				-120.880567 °	-120.811898 °
DWR ID	DWR_NA0010_02A_f_2015_27				
Comment Code					
V1 : Control annual grass and weeds on the levee slopes and easements.					
Inspector Comment

Looking typical view of landward slope.

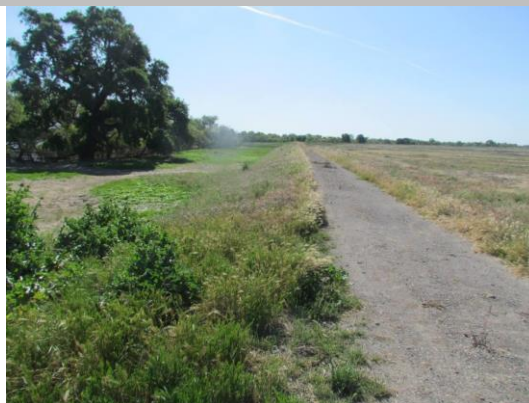
Photo 1 of 1 : SP_2017_NA0010_119_28_20170424_00073.jpg

LM Start	0.00	Rating **	M	Issue No.	28
LM End	7.86	Issue Type +	Ma	Location *	WS
Category	Earthen Levee			GPS Latitude/Longitude	
				Start	End
Item	Vegetation			37.296305 °	37.231303 °
				-120.880567 °	-120.811898 °
DWR ID	DWR_NA0010_02A_f_2015_28				
Comment Code					
V1 : Control annual grass and weeds on the levee slopes and easements.					
Inspector Comment

Looking at typical view of waterward slope.

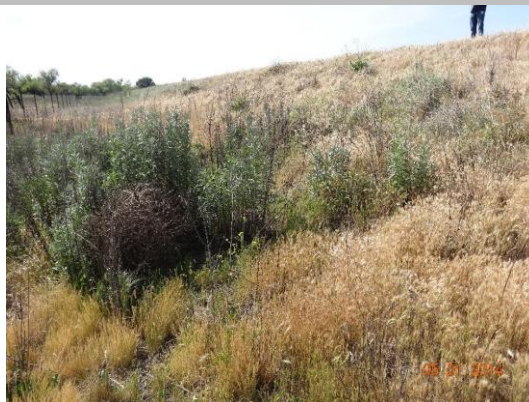
Photo 1 of 3 : UCIP_SP_2017_36503_66102.jpg

Comment Code						
Inspector Comment						
FS_ID:36503						
DS_ID:19652						
EP_NO: N/A						
Repair Type: Non-Urgent						
Crossing Status: Found						
UCIP Comments: Dense vegetation limits the inspector's visibility to identify signs of pipe failure (leaks) along the slope. Recommend removing vegetation along pipe alignment to conduct proper inspection of structure.						
FIELD_STRUCT_DESC: 24-inch CM pipe through the levee, 11.0 feet below the crown. Flap gate on the waterward end. Brass cap No. 139 BM on headwall on the landward side. (USACE-1967). This entry matches the Drainage or Irrigation Structure referenced in O&M manual (HLM 0.24).						
FS Date: 5/1/2014

View of waterward side.

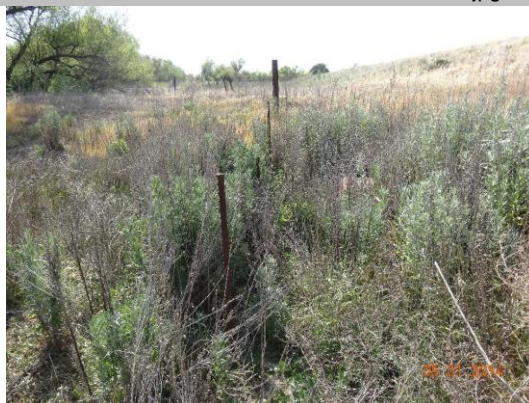
Photo 2 of 3 : UCIP_SP_2017_36503_66101.jpg

Fence along waterward side. No headwall was found on waterward side.

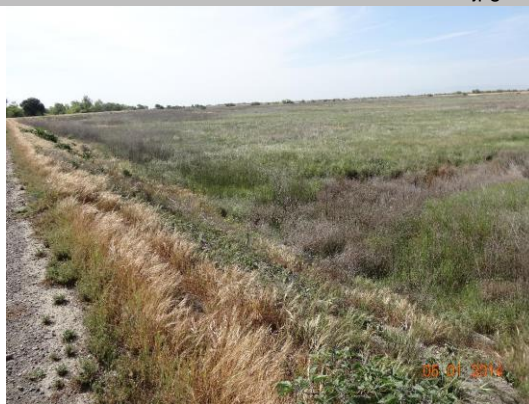
Photo 3 of 3 : UCIP_SP_2017_36503_66100.jpg

View of landward side.

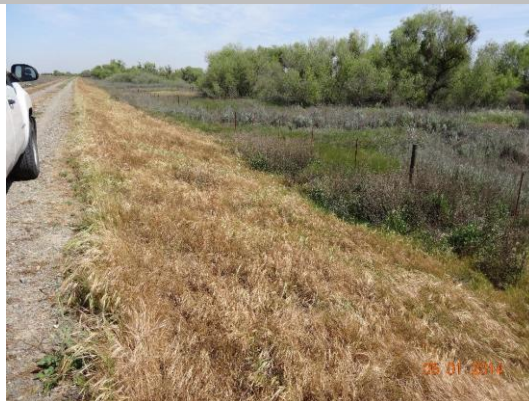
Photo 1 of 3 : UCIP_SP_2017_36504_66106.jpg

FS_ID:36504
DS_ID:19653
EP_NO: N/A
Repair Type: Non-Urgent
Crossing Status: Found
UCIP Comments: Dense vegetation limits the inspector's visibility to identify signs of pipe failure (leaks) along the slope. Recommend removing vegetation along pipe alignment to conduct proper inspection of structure.
FIELD_STRUCT_DESC: 24-inch CM pipe through the levee, 14.8 feet below the crown. Flap gate on the waterward end. Brass cap No. 138 BM on headwall on the landward side. (USACE-1967). This entry matches the Drainage or Irrigation Structure referenced in O&M manual (HLM 0.67).
FS Date: 5/1/2014

View of waterward side.

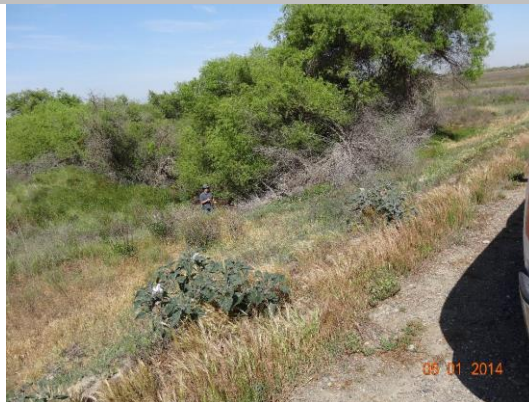
Photo 2 of 3 : UCIP_SP_2017_36504_66105.jpg

View of landward side.

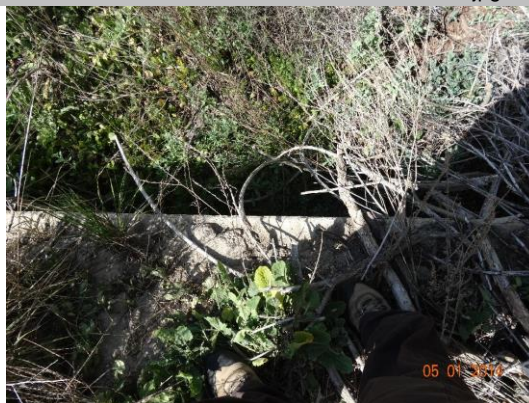
Photo 3 of 3 : UCIP_SP_2017_36504_66104.jpg

Comment Code						
Inspector Comment						
FS_ID:36504 DS_ID:19653 EP_NO: N/A Repair Type: Non-Urgent Crossing Status: Found UCIP Comments: Dense vegetation limits the inspector's visibility to identify signs of pipe failure (leaks) along the slope. Recommend removing vegetation along pipe alignment to conduct proper inspection of structure. FIELD_STRUCT_DESC: 24-inch CM pipe through the levee, 14.8 feet below the crown. Flap gate on the waterward end. Brass cap No. 138 BM on headwall on the landward side. (USACE-1967). This entry matches the Drainage or Irrigation Structure referenced in O&M manual (HLM 0.67). FS Date: 5/1/2014

Concrete headwall found on landward side.

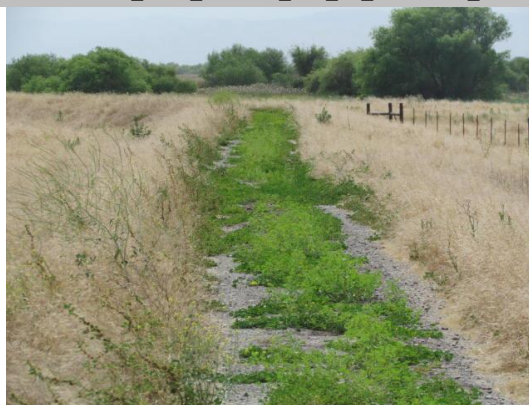
Photo 1 of 1 : SP_2017_NA0010_119_24_20170417_00010.jpg

LM Start	0.69	Rating **	M	Issue No.	24	
LM End	7.83	Issue Type +	Ma	Location *	CR	
Category	Earthen Levee			GPS Latitude/Longitude		
				Start		End
Item	Crown Surface / Depressions / Rutting			37.287788 °	37.231732 °	
				-120.874720 °	-120.812347 °	
DWR ID	DWR_NA0010_02A_s_2016_24					
Comment Code						
C2 : Repair depressions or ruts in the crown or slope.						
Inspector Comment						
Regrade levee rutting and pot holes.

Looking northeast at veg on levee crown.

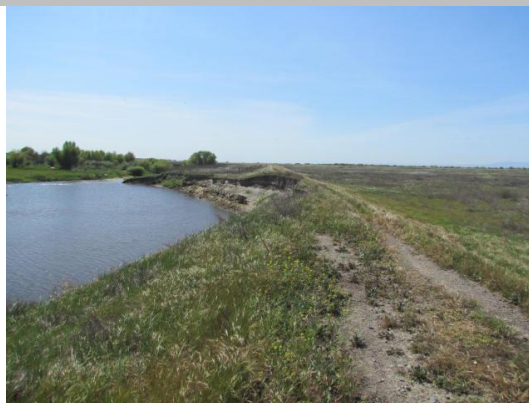
Photo 1 of 4 : SP_2017_NA0010_119_5_20170417_00007.jpg

LM Start	0.75	Rating **	U	Issue No.	5
LM End	0.75	Issue Type +	Ma	Location *	WS
Category	Earthen Levee			GPS Latitude/Longitude	
				Start	End
Item	Erosion / Bank Caving			37.286877 °	37.286877 °
				-120.874222 °	-120.874222 °
DWR ID	DWR_NA0010_02A_s_2012_5				
Comment Code					
E2 : Schedule repair of erosion site prior to the next inspection.					
Inspector Comment					
A field investigation report in on file. For more information and pictures see field investigation report #4301.

Looking south at large erosion on waterside slope. (Spring 2012)

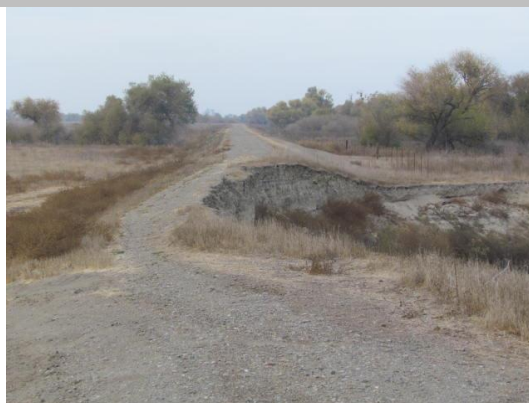
Photo 2 of 4 : SP_2017_NA0010_119_5_20170417_00006.jpg

Looking north at large erosion on waterward slope. (Fall 2013)

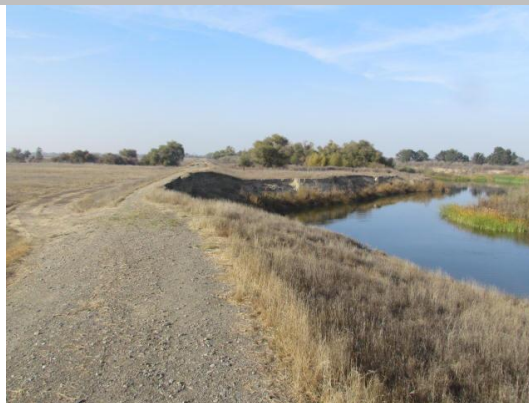
Photo 3 of 4 : SP_2017_NA0010_119_5_20170417_00005.jpg

Looking north at erosion on waterward slope. (Fall 2014)

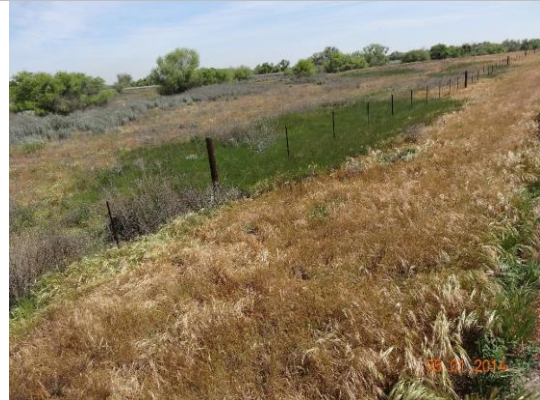
Photo 1 of 3 : UCIP_SP_2017_39363_66113.jpg

Comment Code					
Inspector Comment					
FS_ID:39363 DS_ID:19654 EP_NO: N/A Repair Type: Non-Urgent Crossing Status: Found UCIP Comments: Dense vegetation limits the inspector's visibility to identify signs of pipe failure (leaks) along the slope. Recommend removing vegetation along pipe alignment to conduct proper inspection of structure. Sediment buildup in pipe recommend clearing. FIELD_STRUCT_DESC: 24-inch CM pipe through the levee, 8.6 feet below the crown. Flap gate on the waterward end. Brass cap No. 137 BM on headwall on the landward side. (USACE-1967). This entry matches the Drainage or Irrigation Structure referenced in O&M manual (HLM 1.02). FS Date: 5/1/2014

View of waterward side.

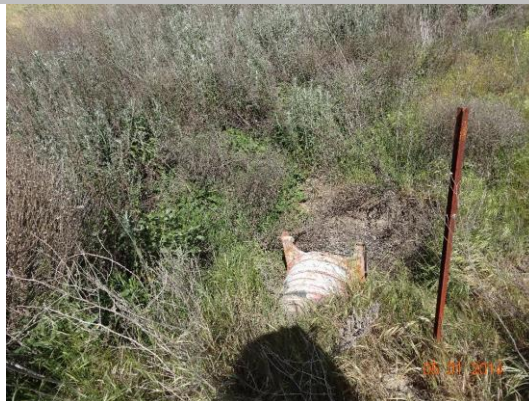
Photo 2 of 3 : UCIP_SP_2017_39363_66112.jpg

FS_ID:39363
DS_ID:19654
EP_NO: N/A
Repair Type: Non-Urgent
Crossing Status: Found
UCIP Comments: Dense vegetation limits the inspector's visibility to identify signs of pipe failure (leaks) along the slope. Recommend removing vegetation along pipe alignment to conduct proper inspection of structure. Sediment buildup in pipe recommend clearing.
FIELD_STRUCT_DESC: 24-inch CM pipe through the levee, 8.6 feet below the crown. Flap gate on the waterward end. Brass cap No. 137 BM on headwall on the landward side. (USACE-1967). This entry matches the Drainage or Irrigation Structure referenced in O&M manual (HLM 1.02).
FS Date: 5/1/2014

Pipe visible on waterward side.

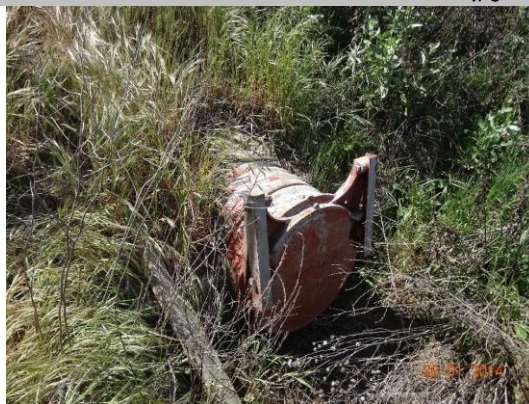
Photo 3 of 3 : UCIP_SP_2017_39363_66111.jpg

Flap gate visible on waterward side.

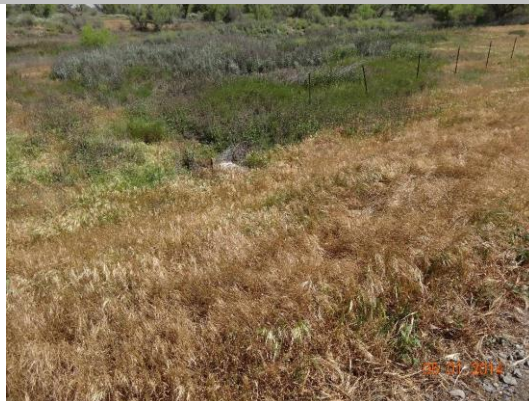
Photo 1 of 3 : UCIP_SP_2017_36506_66114.jpg

FS_ID:36506
DS_ID:19655
EP_NO: N/A
Repair Type: Non-Urgent
Crossing Status: Found
UCIP Comments: Dense vegetation limits the inspector's visibility to identify signs of pipe failure (leaks) along the slope. Recommend removing vegetation along pipe alignment to conduct proper inspection of structure.
FIELD_STRUCT_DESC: 24-inch CM pipe through the levee, 8.6 feet below the crown. Flap gate on the waterward end. Brass cap No. 136 BM on headwall on the landward side. (USACE-1967). This entry matches the Drainage or Irrigation Structure referenced in O&M manual (HLM 1.22).
FS Date: 5/1/2014

Overview of waterward side.

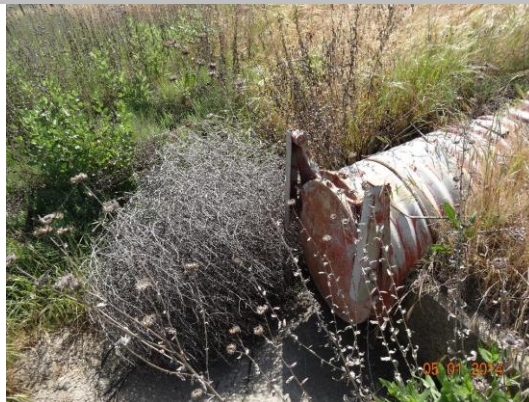
Photo 2 of 3 : UCIP_SP_2017_36506_66117.jpg

Flap gate visible on waterward side.

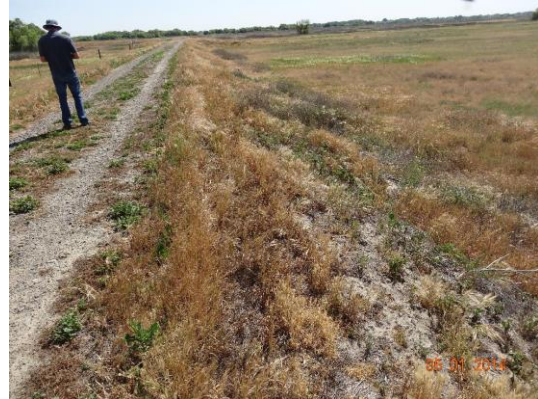
Photo 3 of 3 : UCIP_SP_2017_36506_66116.jpg

FS_ID:36506
DS_ID:19655
EP_NO: N/A
Repair Type: Non-Urgent
Crossing Status: Found
UCIP Comments: Dense vegetation limits the inspector's visibility to identify signs of pipe failure (leaks) along the slope. Recommend removing vegetation along pipe alignment to conduct proper inspection of structure.
FIELD_STRUCT_DESC: 24-inch CM pipe through the levee, 8.6 feet below the crown. Flap gate on the waterward end. Brass cap No. 136 BM on headwall on the landward side. (USACE-1967). This entry matches the Drainage or Irrigation Structure referenced in O&M manual (HLM 1.22).
FS Date: 5/1/2014

View of landward side.

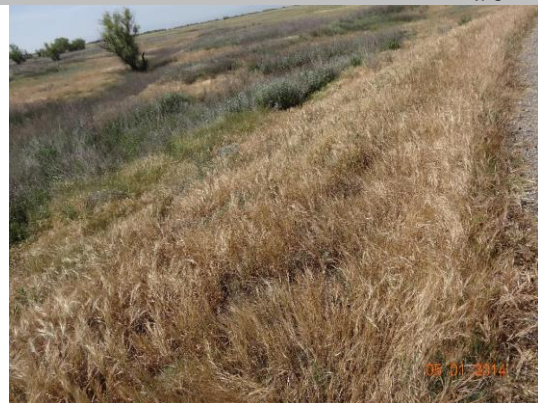
Photo 1 of 3 : UCIP_SP_2017_36507_66120.jpg

FS_ID:36507
DS_ID:19656
EP_NO: N/A
Repair Type: Non-Urgent
Crossing Status: Found
UCIP Comments: Dense vegetation limits the inspector's visibility to identify signs of pipe failure (leaks) along the slope. Recommend removing vegetation along pipe alignment to conduct proper inspection of structure.
FIELD_STRUCT_DESC: 36-inch CM pipe through the levee, 14.6 feet below the crown. Flap gate on the waterward end. Brass cap No. 135 BM on headwall on the landward side. (USACE-1967). This entry matches the Drainage or Irrigation Structure referenced in O&M manual (HLM 1.34).
FS Date: 5/1/2014

View of landward side.

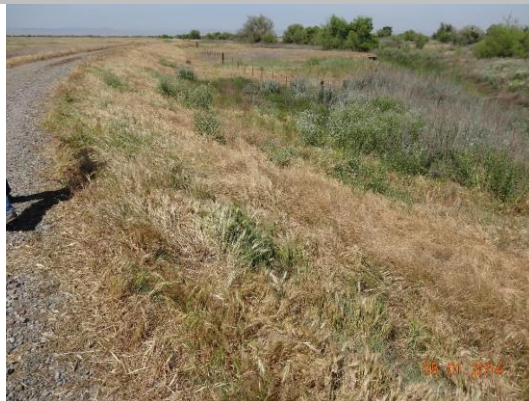
Photo 2 of 3 : UCIP_SP_2017_36507_66119.jpg

Comment Code						
Inspector Comment						
FS_ID:36507 DS_ID:19656 EP_NO: N/A Repair Type: Non-Urgent Crossing Status: Found UCIP Comments: Dense vegetation limits the inspector's visibility to identify signs of pipe failure (leaks) along the slope. Recommend removing vegetation along pipe alignment to conduct proper inspection of structure. FIELD_STRUCT_DESC: 36-inch CM pipe through the levee, 14.6 feet below the crown. Flap gate on the waterward end. Brass cap No. 135 BM on headwall on the landward side. (USACE-1967). This entry matches the Drainage or Irrigation Structure referenced in O&M manual (HLM 1.34). FS Date: 5/1/2014

View of waterward side.

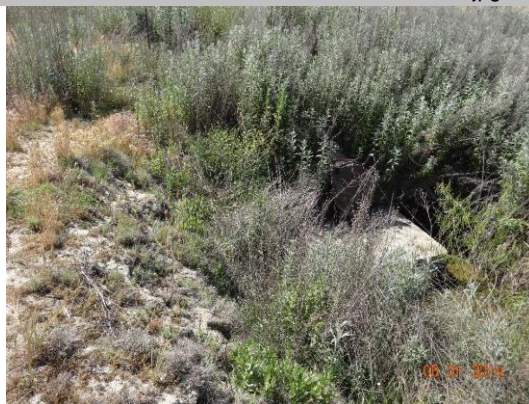
Photo 3 of 3 : UCIP_SP_2017_36507_66118.jpg

Flap gate and concrete apron visible on waterward side.

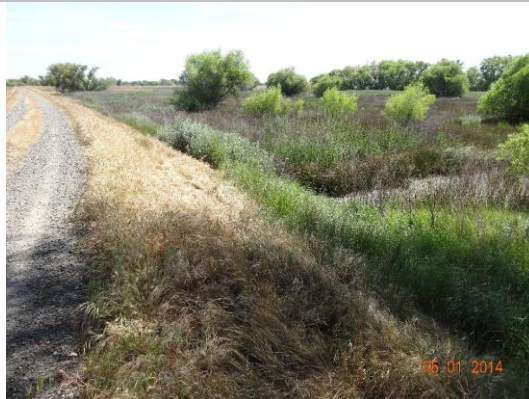
Photo 1 of 3 : UCIP_SP_2017_36508_66124.jpg

FS_ID:36508
 DS_ID:19657
 EP_NO: N/A
 Repair Type: Non-Urgent
 Crossing Status: Found
 UCIP Comments: Dense vegetation limits the inspector's visibility to identify signs of pipe failure (leaks) along the slope. Recommend removing vegetation along pipe alignment to conduct proper inspection of structure.
 FIELD_STRUCT_DESC: 24-inch CM pipe through the levee, 10.2 feet below the crown. Flap gate on the waterward end. Brass cap No. 135 BM on headwall on the landward side. (USACE-1967). This entry matches the Drainage or Irrigation Structure referenced in O&M manual (HLM 1.62).
 FS Date: 5/1/2014

Overview of landward side.

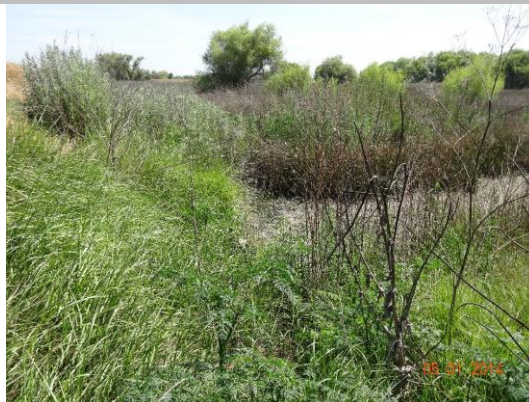
Photo 2 of 3 : UCIP_SP_2017_36508_66123.jpg

Dense vegetation along levee slope and toe.

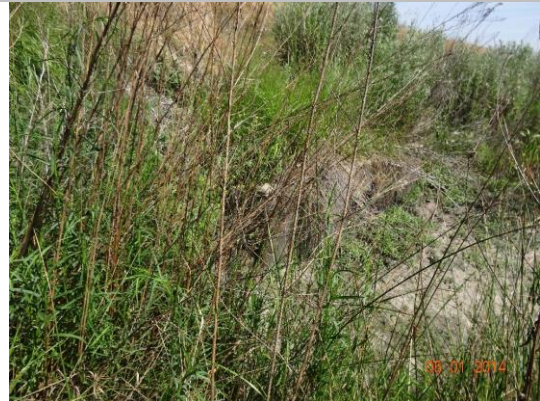
Photo 3 of 3 : UCIP_SP_2017_36508_66122.jpg

Comment Code						
Inspector Comment						
FS_ID:36508 DS_ID:19657 EP_NO: N/A Repair Type: Non-Urgent Crossing Status: Found UCIP Comments: Dense vegetation limits the inspector's visibility to identify signs of pipe failure (leaks) along the slope. Recommend removing vegetation along pipe alignment to conduct proper inspection of structure. FIELD_STRUCT_DESC: 24-inch CM pipe through the levee, 10.2 feet below the crown. Flap gate on the waterward end. Brass cap No. 135 BM on headwall on the landward side. (USACE-1967). This entry matches the Drainage or Irrigation Structure referenced in O&M manual (HLM 1.62). FS Date: 5/1/2014

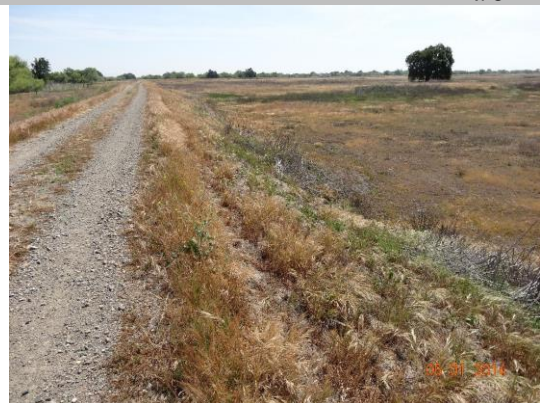
Photo 1 of 3 : UCIP_SP_2017_36509_66129.jpg

LM Start	1.85	Rating **	M	Issue No.	35
LM End	1.85	Issue Type +	Ma	Location *	WS
Category	Supplemental			GPS Latitude/Longitude	
				Start	End
Item	DWR UCIP LMA Responsibility			37.290836 °	37.290836 °
				-120.858882 °	-120.858882 °
DWR ID					
Comment Code					
Inspector Comment					
FS_ID:36509 DS_ID:19658 EP_NO: N/A Repair Type: Non-Urgent Crossing Status: Found UCIP Comments: Dense vegetation limits the inspector's visibility to identify signs of pipe failure (leaks) along the slope. Recommend removing vegetation along pipe alignment to conduct proper inspection of structure. FIELD_STRUCT_DESC: 24-inch CM pipe through the levee, 10.7 feet below the crown. Flap gate on the waterward end. Brass cap No. 135 BM on headwall on the landward side. (USACE-1967). This entry matches the Drainage or Irrigation Structure referenced in O&M manual (HLM 1.86). ES Date: 5/1/2014

View of landward side.

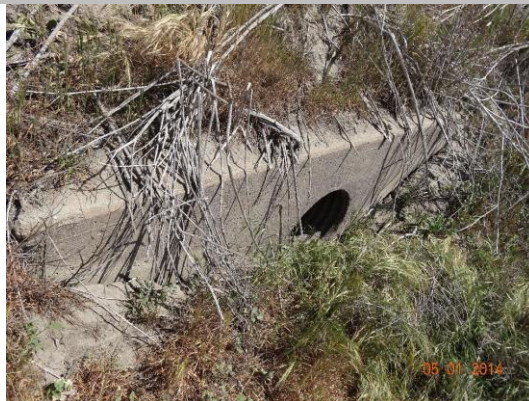
Photo 2 of 3 : UCIP_SP_2017_36509_66128.jpg

FS_ID:36509
DS_ID:19658
EP_NO: N/A
Repair Type: Non-Urgent
Crossing Status: Found
UCIP Comments: Dense vegetation limits the inspector's visibility to identify signs of pipe failure (leaks) along the slope. Recommend removing vegetation along pipe alignment to conduct proper inspection of structure.
FIELD_STRUCT_DESC: 24-inch CM pipe through the levee, 10.7 feet below the crown. Flap gate on the waterward end. Brass cap No. 135 BM on headwall on the landward side. (USACE-1967). This entry matches the Drainage or Irrigation Structure referenced in O&M manual (HLM 1.86).
FS Date: 5/1/2014

Concrete headwall visible on landward side.

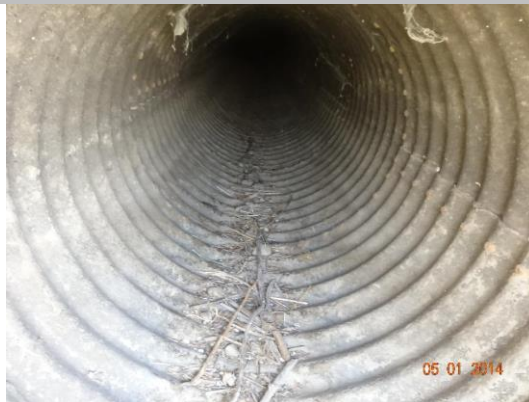
Photo 3 of 3 : UCIP_SP_2017_36509_66127.jpg

Inside view of pipe from landward side.

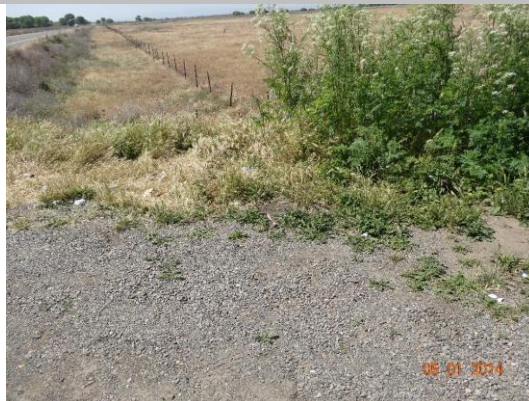
Photo 1 of 3 : UCIP_SP_2017_36510_66133.jpg

FS_ID:36510
DS_ID:19659
EP_NO: N/A
Repair Type: Non-Urgent
Crossing Status: Found
UCIP Comments: Dense vegetation limits the inspector's visibility to identify signs of pipe failure (leaks) along the slope. Recommend removing vegetation along pipe alignment to conduct proper inspection of structure.
FIELD_STRUCT_DESC: 24-inch CM pipe through the levee, 7.0 feet below the crown. Flap gate on the waterward end. Brass cap No. 135 BM on headwall on the landward side. (USACE-1967). This entry matches the Drainage or Irrigation Structure referenced in O&M manual (HLM 2.30).
FS Date: 5/1/2014

View of landward side.

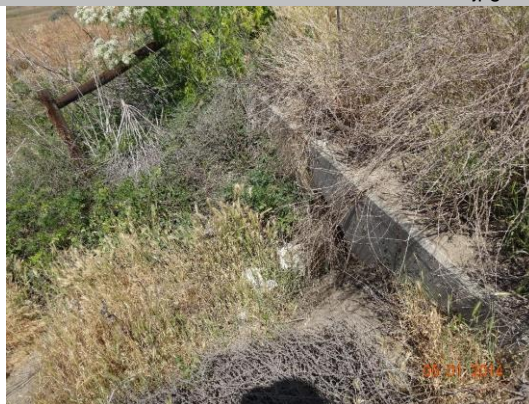
Photo 2 of 3 : UCIP_SP_2017_36510_66132.jpg

Concrete headwall visible on landward side.

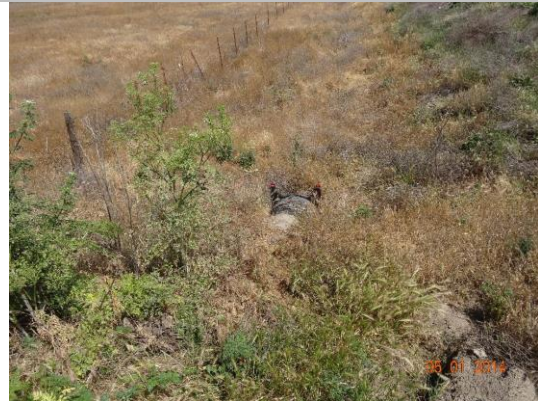
Photo 3 of 3 : UCIP_SP_2017_36510_66131.jpg

Comment Code						
Inspector Comment						
FS_ID:36510 DS_ID:19659 EP_NO: N/A Repair Type: Non-Urgent Crossing Status: Found UCIP Comments: Dense vegetation limits the inspector's visibility to identify signs of pipe failure (leaks) along the slope. Recommend removing vegetation along pipe alignment to conduct proper inspection of structure. FIELD_STRUCT_DESC: 24-inch CM pipe through the levee, 7.0 feet below the crown. Flap gate on the waterward end. Brass cap No. 135 BM on headwall on the landward side. (USACE-1967). This entry matches the Drainage or Irrigation Structure referenced in O&M manual (HLM 2.30). FS Date: 5/1/2014

View of pipe through levee visible on waterward side.

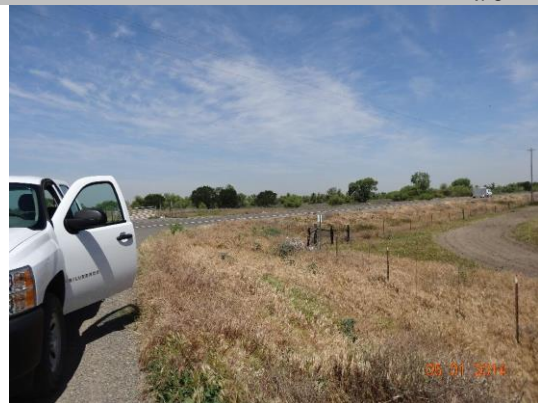
Photo 1 of 3 : UCIP_SP_2017_36511_66137.jpg

LM Start	2.30	Rating **	M	Issue No.	37
LM End	2.30	Issue Type +	Ma	Location *	WS
Category	Supplemental			GPS Latitude/Longitude	
				Start	End
Item	DWR UCIP LMA Responsibility			37.291532 °	37.291532 °
				-120.851203 °	-120.851203 °
DWR ID					
Comment Code					
Inspector Comment					
FS_ID:36511 DS_ID:19660 EP_NO: N/A Repair Type: Non-Urgent Crossing Status: Found UCIP Comments: Dense vegetation limits the inspector's visibility to identify signs of pipe failure (leaks) along the slope. Recommend removing vegetation along pipe alignment to conduct proper inspection of structure. FIELD_STRUCT_DESC: 24-inch CM pipe through the levee, 7.0 feet below the crown. Flap gate on the waterward end. Brass cap No. 135 BM on headwall on the landward side. (USACE-1967). This entry matches the Drainage or Irrigation Structure referenced in O&M manual (HLM 2.32). FS Date: 5/1/2014

View of waterward side.

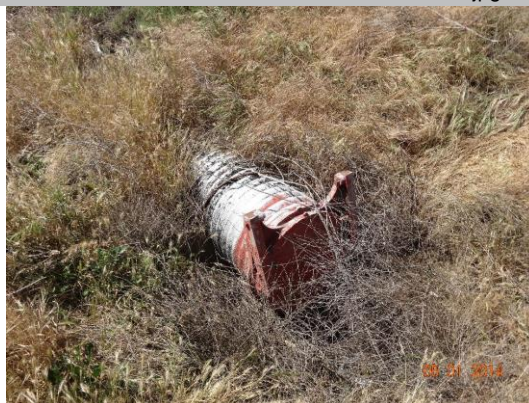
Photo 2 of 3 : UCIP_SP_2017_36511_66136.jpg

FS_ID:36511
DS_ID:19660
EP_NO: N/A
Repair Type: Non-Urgent
Crossing Status: Found
UCIP Comments: Dense vegetation limits the inspector's visibility to identify signs of pipe failure (leaks) along the slope. Recommend removing vegetation along pipe alignment to conduct proper inspection of structure.
FIELD_STRUCT_DESC: 24-inch CM pipe through the levee, 7.0 feet below the crown. Flap gate on the waterward end. Brass cap No. 135 BM on headwall on the landward side. (USACE-1967). This entry matches the Drainage or Irrigation Structure referenced in O&M manual (HLM 2.32).
FS Date: 5/1/2014

Flap gate visible on waterward side.

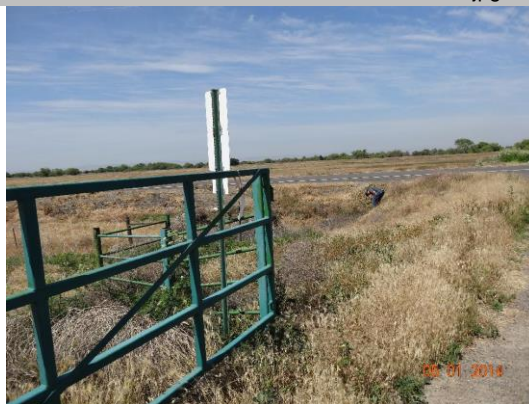
Photo 3 of 3 : UCIP_SP_2017_36511_66138.jpg

Overview of landward slope.

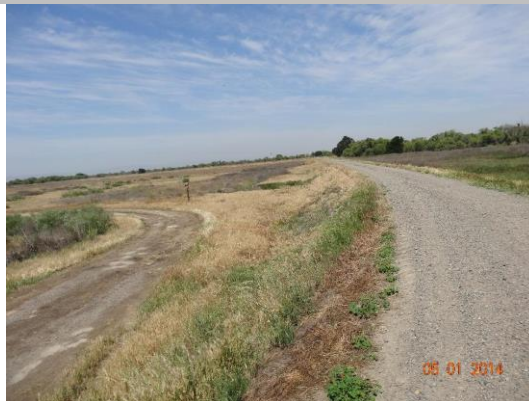
Photo 1 of 3 : UCIP_SP_2017_36512_66142.jpg

FS_ID:36512
DS_ID:19661
EP_NO: N/A
Repair Type: Non-Urgent
Crossing Status: Found
UCIP Comments: Dense vegetation limits the inspector's visibility to identify signs of pipe failure (leaks) along the slope. Recommend removing vegetation along pipe alignment to conduct proper inspection of structure.
FIELD_STRUCT_DESC: 24-inch CM pipe through the levee, 10.0 feet below the crown. Flap gate on the waterward end. Brass cap No. 130 BM on headwall on the landward side. (USACE-1967). This entry matches the Drainage or Irrigation Structure referenced in O&M manual (HLM 2.59).
FS Date: 5/1/2014

View of landward side.

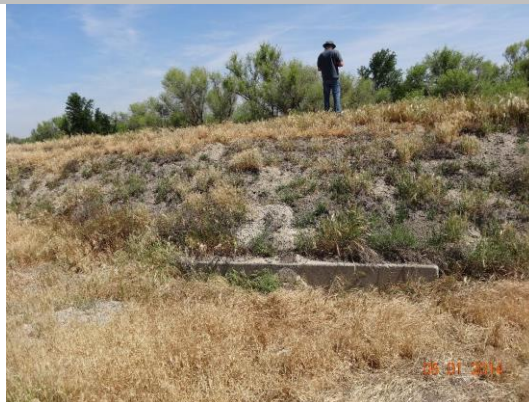
Photo 2 of 3 : UCIP_SP_2017_36512_66141.jpg

Concrete headwall visible on landward side.

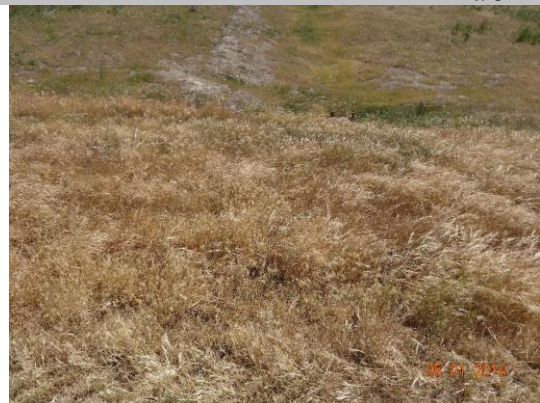
Photo 1 of 3 : UCIP_SP_2017_36513_66145.jpg

LM Start	2.95	Rating **	M	Issue No.	39
LM End	2.95	Issue Type +	Ma	Location *	WS
Category	Supplemental			GPS Latitude/Longitude	
				Start	End
Item	DWR UCIP LMA Responsibility			37.284326 °	37.284326 °
				-120.845157 °	-120.845157 °
DWR ID					
Comment Code					
Inspector Comment					
FS_ID:36513 DS_ID:19662 EP_NO: N/A Repair Type: Non-Urgent Crossing Status: Found UCIP Comments: Dense vegetation limits the inspector's visibility to identify signs of pipe failure (leaks) along the slope. Recommend removing vegetation along pipe alignment to conduct proper inspection of structure. FIELD_STRUCT_DESC: 24-inch CM pipe through the levee, 10.0 feet below the crown. Flap gate on the waterward end. Brass cap No. 130 BM on headwall on the landward side. (USACE-1967). This entry matches the Drainage or Irrigation Structure referenced in O&M manual (HLM 2.96). FS Date: 5/1/2014

View of waterward side.

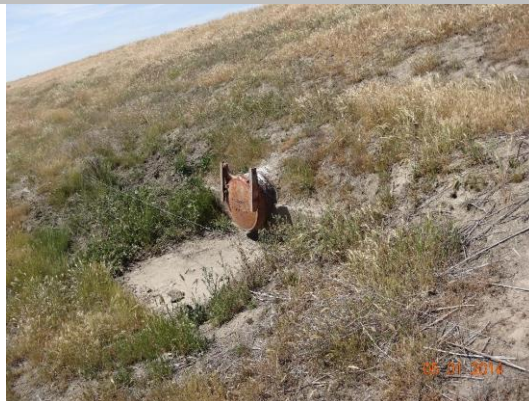
Photo 2 of 3 : UCIP_SP_2017_36513_66144.jpg

FS_ID:36513
DS_ID:19662
EP_NO: N/A
Repair Type: Non-Urgent
Crossing Status: Found
UCIP Comments: Dense vegetation limits the inspector's visibility to identify signs of pipe failure (leaks) along the slope. Recommend removing vegetation along pipe alignment to conduct proper inspection of structure.
FIELD_STRUCT_DESC: 24-inch CM pipe through the levee, 10.0 feet below the crown. Flap gate on the waterward end. Brass cap No. 130 BM on headwall on the landward side. (USACE-1967). This entry matches the Drainage or Irrigation Structure referenced in O&M manual (HLM 2.96).
FS Date: 5/1/2014

Flap gate visible on waterward side.

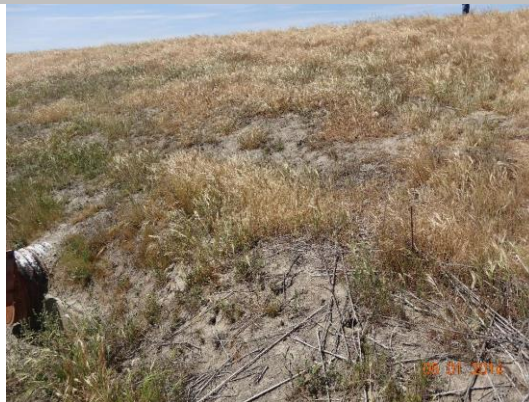
Photo 3 of 3 : UCIP_SP_2017_36513_66149.jpg

View of slope on waterward side.

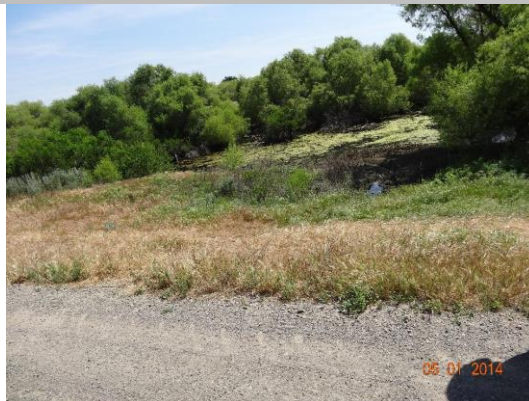
Photo 1 of 3 : UCIP_SP_2017_36514_66151.jpg

FS_ID:36514
DS_ID:19665
EP_NO: N/A
Repair Type: Non-Urgent
Crossing Status: Found
UCIP Comments: Dense vegetation limits the inspector's visibility to identify signs of pipe failure (leaks) along the slope. Recommend removing vegetation along pipe alignment to conduct proper inspection of structure.
FIELD_STRUCT_DESC: 24-inch CM pipe through the levee, 12.4 feet below the crown. Flap gate on the waterward end. Brass cap No. 130 BM on headwall on the landward side. (USACE-1967). This entry matches the Drainage or Irrigation Structure referenced in O&M manual (HLM 3.29).
FS Date: 5/1/2014

View of waterward side.

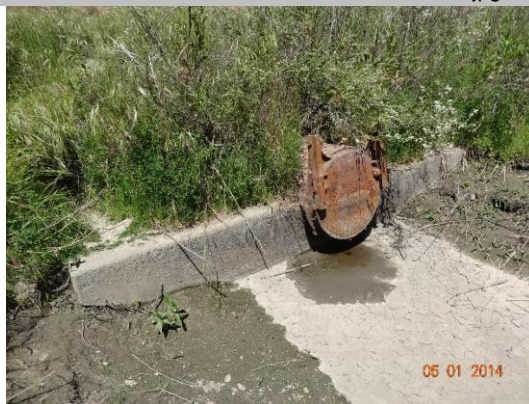
Photo 2 of 3 : UCIP_SP_2017_36514_66153.jpg

Flap gate visible on waterward side.

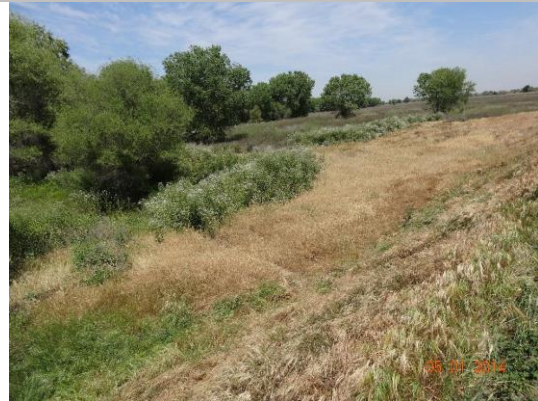
Photo 3 of 3 : UCIP_SP_2017_36514_66152.jpg

Comment Code						
Inspector Comment						
FS_ID:36514 DS_ID:19665 EP_NO: N/A Repair Type: Non-Urgent Crossing Status: Found UCIP Comments: Dense vegetation limits the inspector's visibility to identify signs of pipe failure (leaks) along the slope. Recommend removing vegetation along pipe alignment to conduct proper inspection of structure. FIELD_STRUCT_DESC: 24-inch CM pipe through the levee, 12.4 feet below the crown. Flap gate on the waterward end. Brass cap No. 130 BM on headwall on the landward side. (USACE-1967). This entry matches the Drainage or Irrigation Structure referenced in O&M manual (HLM 3.29). FS Date: 5/1/2014

View of landward side.

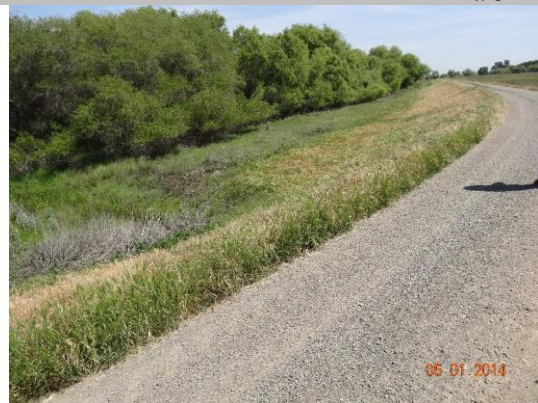
Photo 1 of 3 : UCIP_SP_2017_36515_66155.jpg

Comment Code					
Inspector Comment					
FS_ID:36515					
DS_ID:19666					
EP_NO: N/A					
Repair Type: Non-Urgent					
Crossing Status: Found					
UCIP Comments: Dense vegetation limits the inspector's visibility to identify signs of pipe failure (leaks) along the slope. Recommend removing vegetation along pipe alignment to conduct proper inspection of structure.					
FIELD_STRUCT_DESC: 24-inch CM pipe through the levee, 10.0 feet below the crown. Flap gate on the waterward end. Brass cap No. 130 BM on headwall on the landward side. (USACE-1967). This entry matches the Drainage or Irrigation Structure referenced in O&M manual (HLM 3.62).					
FS Date: 5/1/2014

View of waterward side.

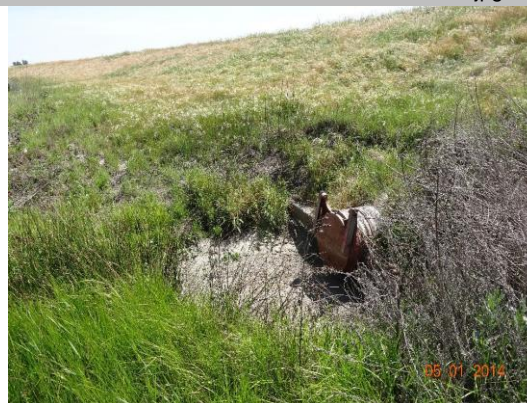
Photo 2 of 3 : UCIP_SP_2017_36515_66154.jpg

Comment Code						
Inspector Comment						
FS_ID:36515 DS_ID:19666 EP_NO: N/A Repair Type: Non-Urgent Crossing Status: Found UCIP Comments: Dense vegetation limits the inspector's visibility to identify signs of pipe failure (leaks) along the slope. Recommend removing vegetation along pipe alignment to conduct proper inspection of structure. FIELD_STRUCT_DESC: 24-inch CM pipe through the levee, 10.0 feet below the crown. Flap gate on the waterward end. Brass cap No. 130 BM on headwall on the landward side. (USACE-1967). This entry matches the Drainage or Irrigation Structure referenced in O&M manual (HLM 3.62). FS Date: 5/1/2014

Flap gate visible on waterward side.

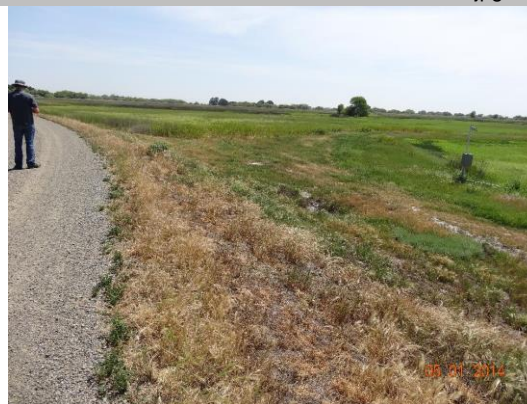
Photo 3 of 3 : UCIP_SP_2017_36515_66156.jpg

View of landward side.

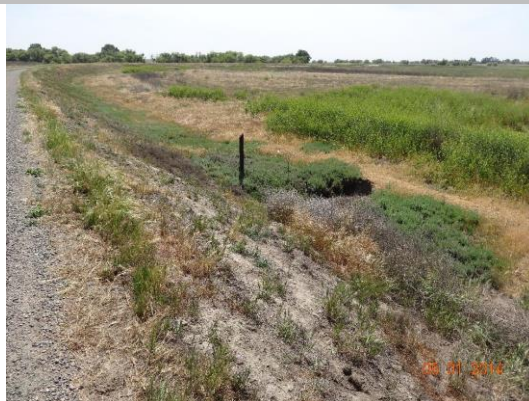
Photo 1 of 3 : UCIP_SP_2017_39364_66161.jpg

FS_ID:39364
DS_ID:19667
EP_NO: N/A
Repair Type: Non-Urgent
Crossing Status: Found
UCIP Comments: Signs of erosion or sink hole present on landward toe--Need to contact owner. Dense vegetation limits the inspector's visibility to identify signs of pipe failure (leaks) along the slope. Recommend removing vegetation along pipe alignment to conduct proper inspection of structure.
FIELD_STRUCT_DESC: 24-inch CM pipe through the levee, 8.6 feet below the crown. Flap gate on the waterward end. Brass cap No. 130 BM on headwall on the landward side. (USACE-1967). This entry matches the Drainage or Irrigation Structure referenced in O&M manual (HLM 3.95).
FS Date: 5/1/2014

View of landward side.

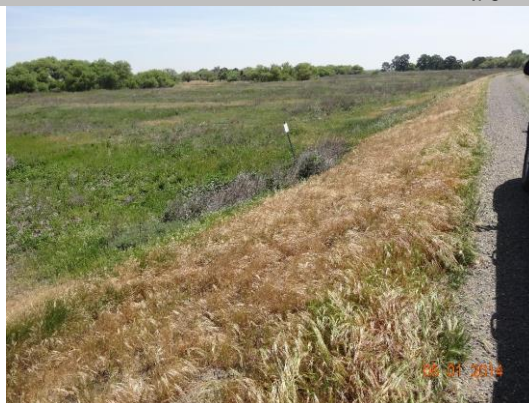
Photo 2 of 3 : UCIP_SP_2017_39364_66160.jpg

View of waterward side.

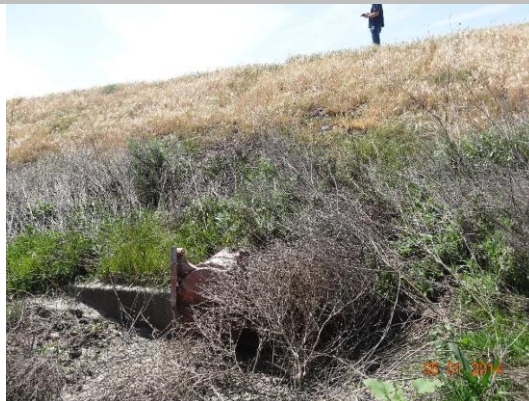
Photo 3 of 3 : UCIP_SP_2017_39364_66159.jpg

Comment Code						
Inspector Comment						
FS_ID:39364						
DS_ID:19667						
EP_NO: N/A						
Repair Type: Non-Urgent						
Crossing Status: Found						
UCIP Comments: Signs of erosion or sink hole present on landward toe--Need to contact owner. Dense vegetation limits the inspector's visibility to identify signs of pipe failure (leaks) along the slope.						
Recommend removing vegetation along pipe alignment to conduct proper inspection of structure.						
FIELD_STRUCT_DESC: 24-inch CM pipe through the levee, 8.6 feet below the crown. Flap gate on the waterward end. Brass cap No. 130 BM on headwall on the landward side. (USACE-1967). This entry matches the Drainage or Irrigation Structure referenced in O&M manual (HLM 3.95).						
FS Date: 5/1/2014

Flap gate and concrete headwall visible through dense vegetation.

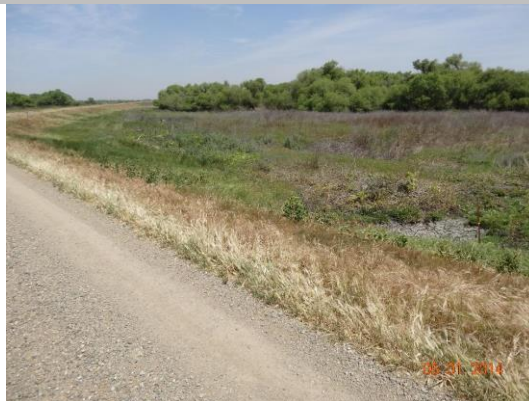
Photo 1 of 3 : UCIP_SP_2017_36517_66167.jpg

FS_ID:36517
DS_ID:19668
EP_NO: N/A
Repair Type: Non-Urgent
Crossing Status: Found
UCIP Comments: Dense vegetation limits the inspector's visibility to identify signs of pipe failure (leaks) along the slope. Recommend removing vegetation along pipe alignment to conduct proper inspection of structure.
FIELD_STRUCT_DESC: 24-inch CM pipe through the levee, 8.0 feet below the crown. Flap gate on the waterward end. Brass cap No. 125 BM on headwall on the landward side. (USACE-1967). This entry matches the Drainage or Irrigation Structure referenced in O&M manual (HLM 5.43).
FS Date: 5/1/2014

View of waterward side.

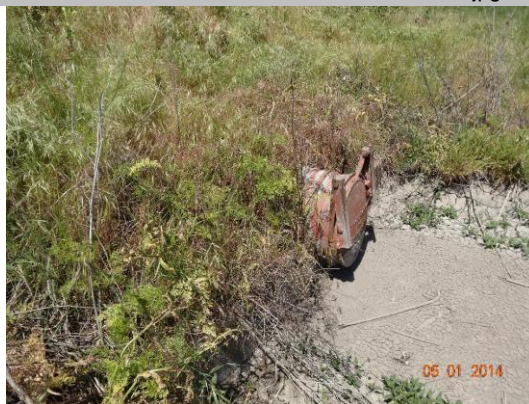
Photo 2 of 3 : UCIP_SP_2017_36517_66166.jpg

Flap gate visible on waterward side.

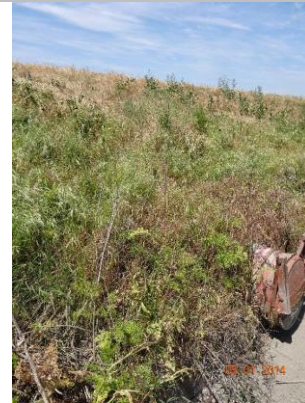
Photo 3 of 3 : UCIP_SP_2017_36517_66165.jpg

Comment Code						
Inspector Comment						
FS_ID:36517 DS_ID:19668 EP_NO: N/A Repair Type: Non-Urgent Crossing Status: Found UCIP Comments: Dense vegetation limits the inspector's visibility to identify signs of pipe failure (leaks) along the slope. Recommend removing vegetation along pipe alignment to conduct proper inspection of structure. FIELD_STRUCT_DESC: 24-inch CM pipe through the levee, 8.0 feet below the crown. Flap gate on the waterward end. Brass cap No. 125 BM on headwall on the landward side. (USACE-1967). This entry matches the Drainage or Irrigation Structure referenced in O&M manual (HLM 5.43). FS Date: 5/1/2014

View of waterward slope covered by vegetation.

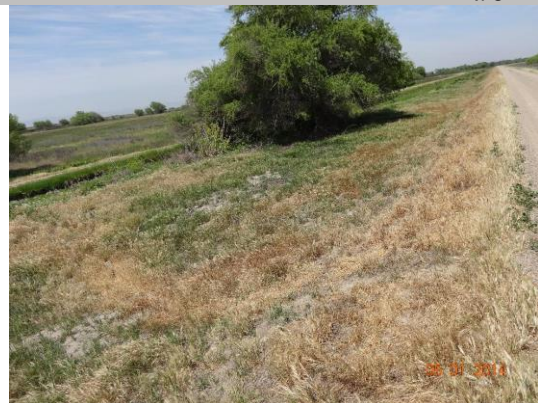
Photo 1 of 2 : UCIP_SP_2017_36518_66171.jpg

LM Start	6.03	Rating **	M	Issue No.	44
LM End	6.03	Issue Type +	Ma	Location *	WS
Category	Supplemental			GPS Latitude/Longitude	
				Start	End
Item	DWR UCIP LMA Responsibility			37.253527 °	37.253527 °
				-120.823991 °	-120.823991 °
DWR ID					
Comment Code					
Inspector Comment					
FS_ID:36518 DS_ID:19669 EP_NO: N/A Repair Type: Non-Urgent Crossing Status: Found UCIP Comments: Dense vegetation limits the inspector's visibility to identify signs of pipe failure (leaks) along the slope. Recommend removing vegetation along pipe alignment to conduct proper inspection of structure. FIELD_STRUCT_DESC: 24-inch CM pipe through the levee, 7.7 feet below the crown. Flap gate on the waterward end. Brass cap No. 125 BM on headwall on the landward side. (USACE-1967). This entry matches the Drainage or Irrigation Structure referenced in O&M manual (HLM 6.06). FS Date: 5/1/2014

View of landward side.

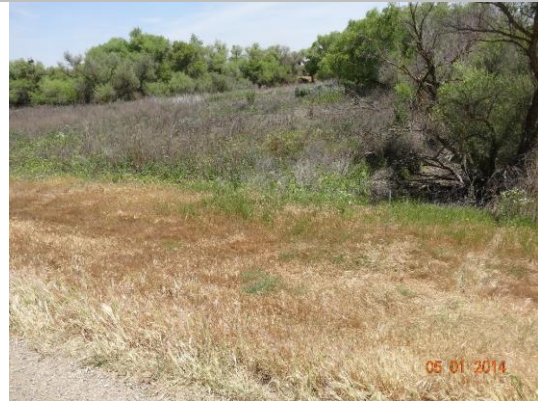
Photo 2 of 2 : UCIP_SP_2017_36518_66170.jpg

LM Start	6.03	Rating **	M	Issue No.	44 (cont)
LM End	6.03	Issue Type +	Ma	Location *	WS
Category	Supplemental			GPS Latitude/Longitude	
				Start	End
Item	DWR UCIP LMA Responsibility			37.253527 °	37.253527 °
				-120.823991 °	-120.823991 °
DWR ID					
Comment Code					
Inspector Comment					
FS_ID:36518 DS_ID:19669 EP_NO: N/A Repair Type: Non-Urgent Crossing Status: Found UCIP Comments: Dense vegetation limits the inspector's visibility to identify signs of pipe failure (leaks) along the slope. Recommend removing vegetation along pipe alignment to conduct proper inspection of structure. FIELD_STRUCT_DESC: 24-inch CM pipe through the levee, 7.7 feet below the crown. Flap gate on the waterward end. Brass cap No. 125 BM on headwall on the landward side. (USACE-1967). This entry matches the Drainage or Irrigation Structure referenced in O&M manual (HLM 6.06). FS Date: 5/1/2014

View of waterward side.

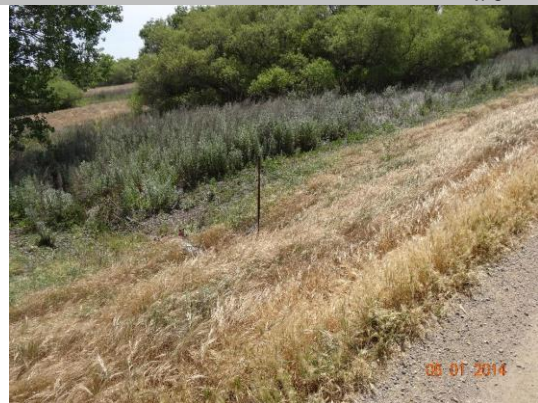
Photo 1 of 3 : UCIP_SP_2017_36519_66173.jpg

Comment Code					
Inspector Comment					
FS_ID:36519					
DS_ID:19670					
EP_NO: N/A					
Repair Type: Non-Urgent					
Crossing Status: Found					
UCIP Comments: Dense vegetation limits the inspector's visibility to identify signs of pipe failure (leaks) along the slope. Recommend removing vegetation along pipe alignment to conduct proper inspection of structure.					
FIELD_STRUCT_DESC: 24-inch CM pipe through the levee, 7.7 feet below the crown. Flap gate on the waterward end. Brass cap No. 125 BM on headwall on the landward side. (USACE-1967). This entry matches the Drainage or Irrigation Structure referenced in O&M manual (HLM 6.50).					
FS Date: 5/1/2014

View of waterward side.

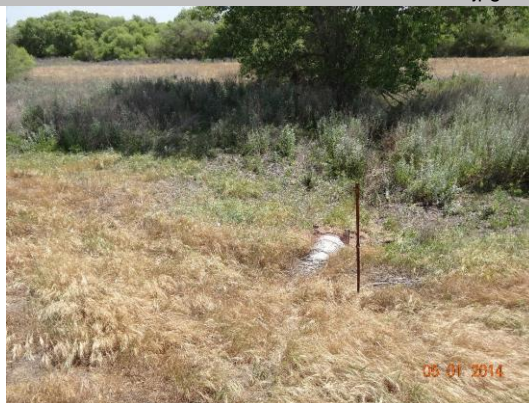
Photo 2 of 3 : UCIP_SP_2017_36519_66172.jpg

Comment Code						
Inspector Comment						
FS_ID:36519 DS_ID:19670 EP_NO: N/A Repair Type: Non-Urgent Crossing Status: Found UCIP Comments: Dense vegetation limits the inspector's visibility to identify signs of pipe failure (leaks) along the slope. Recommend removing vegetation along pipe alignment to conduct proper inspection of structure. FIELD_STRUCT_DESC: 24-inch CM pipe through the levee, 7.7 feet below the crown. Flap gate on the waterward end. Brass cap No. 125 BM on headwall on the landward side. (USACE-1967). This entry matches the Drainage or Irrigation Structure referenced in O&M manual (HLM 6.50). FS Date: 5/1/2014

Crossing and flap gate visible on waterward side.

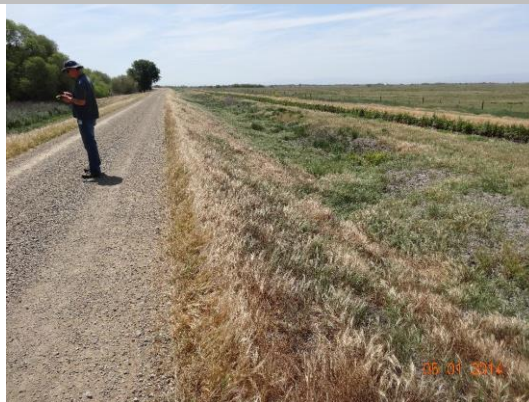
Photo 3 of 3 : UCIP_SP_2017_36519_66174.jpg

Overview of levee crown and landward slope.

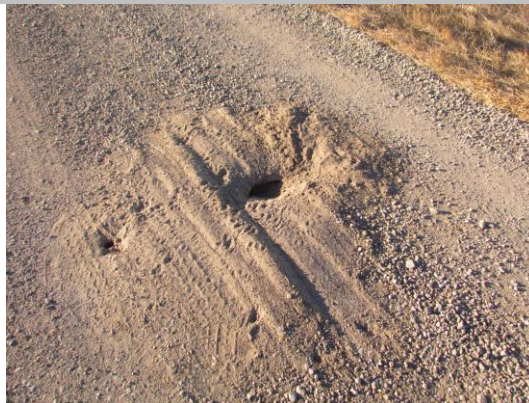
Photo 1 of 2 : SP_2017_NA0010_119_22_20170417_00008.jpg

LM Start	6.85	Rating **	M	Issue No.	22
LM End	6.85	Issue Type +	Ma	Location *	CR
Category	Earthen Levee			GPS Latitude/Longitude	
				Start	End
Item	Animal Control			37.242833 °	37.242833 °
				-120.822270 °	-120.822270 °
DWR ID	DWR_NA0010_02A_f_2016_22				
Comment Code					
A1 : Exterminate rodents and backfill and compact or grout burrows.					
Inspector Comment					
Noticed several burrow holes on the levee crown. It does not seem to be rodent holes or gopher holes. It could be moles.

Looking at rodent hole on levee crown.

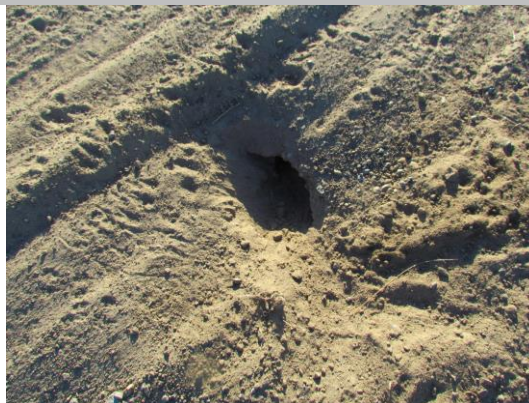
Photo 2 of 2 : SP_2017_NA0010_119_22_20170417_00009.jpg

Looking at close-up of rodent hole on levee crown.

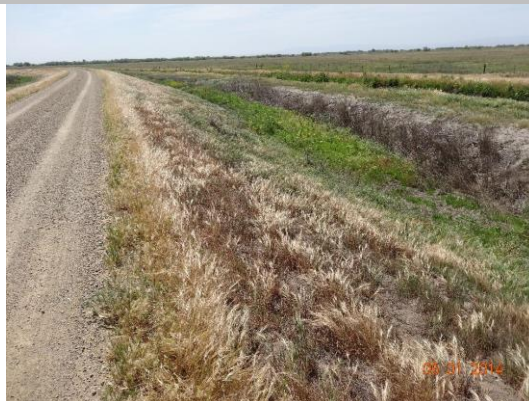
Photo 1 of 3 : UCIP_SP_2017_39365_66178.jpg

Comment Code					
Inspector Comment					
FS_ID:39365 DS_ID:19671 EP_NO: N/A Repair Type: Non-Urgent Crossing Status: Found UCIP Comments: Dense vegetation limits the inspector's visibility to identify signs of pipe failure (leaks) along the slope. Recommend removing vegetation along pipe alignment to conduct proper inspection of structure. Pipe extension visible on landward side--need to contact owner for additional information about extension/modification. FIELD_STRUCT_DESC: 24-inch CM pipe through the levee, 12.6 feet below the crown. Flap gate on the waterward end. Brass cap No. 125 BM on headwall on the landward side. (USACE-1967). This entry matches the Drainage or Irrigation Structure referenced in O&M manual (HLM 7.05). FS Date: 5/1/2014

View of landward side.

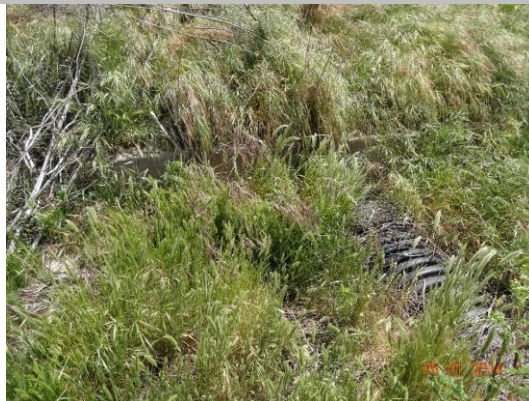
Photo 2 of 3 : UCIP_SP_2017_39365_66177.jpg

Pipe extension visible on landward side attached to inlet at concrete headwall.

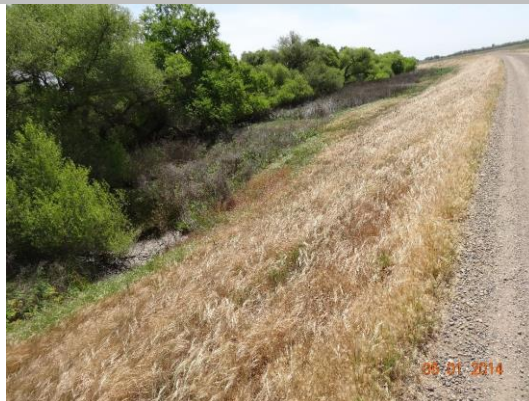
Photo 3 of 3 : UCIP_SP_2017_39365_66176.jpg

Comment Code					
Inspector Comment					
FS_ID:39365 DS_ID:19671 EP_NO: N/A Repair Type: Non-Urgent Crossing Status: Found UCIP Comments: Dense vegetation limits the inspector's visibility to identify signs of pipe failure (leaks) along the slope. Recommend removing vegetation along pipe alignment to conduct proper inspection of structure. Pipe extension visible on landward side--need to contact owner for additional information about extension/modification. FIELD_STRUCT_DESC: 24-inch CM pipe through the levee, 12.6 feet below the crown. Flap gate on the waterward end. Brass cap No. 125 BM on headwall on the landward side. (USACE-1967). This entry matches the Drainage or Irrigation Structure referenced in O&M manual (HLM 7.05). FS Date: 5/1/2014

View of waterward side.

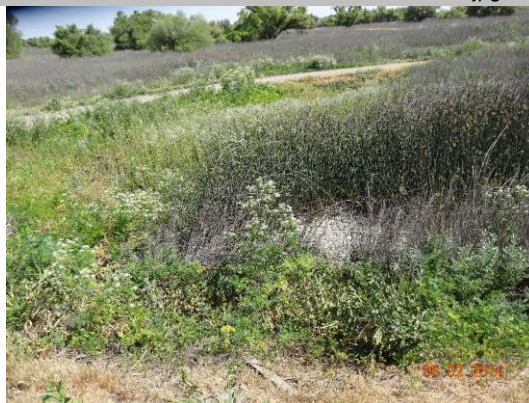
Photo 1 of 3 : UCIP_SP_2017_36521_66183.jpg

FS_ID:36521
DS_ID:19673
EP_NO: N/A
Repair Type: Non-Urgent
Crossing Status: Found
UCIP Comments: Dense vegetation limits the inspector's visibility to identify signs of pipe failure (leaks) along the slope. Recommend removing vegetation along pipe alignment to conduct proper inspection of structure.
FIELD_STRUCT_DESC: 24-inch CM pipe through the levee, 8.0 feet below the crown. Flap gate on the waterward end. Brass cap No. 125 BM on headwall on the landward side. (USACE-1967). This entry matches the Drainage or Irrigation Structure referenced in O&M manual (HLM 7.77).
FS Date: 5/1/2014

View of waterward side.

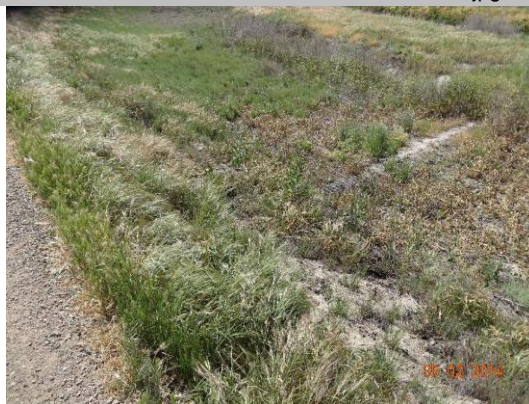
Photo 2 of 3 : UCIP_SP_2017_36521_66182.jpg

View of landward side.

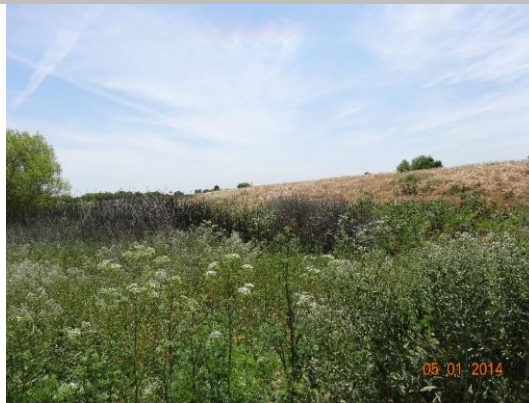
Photo 3 of 3 : UCIP_SP_2017_36521_66181.jpg

Comment Code						
Inspector Comment						
FS_ID:36521 DS_ID:19673 EP_NO: N/A Repair Type: Non-Urgent Crossing Status: Found UCIP Comments: Dense vegetation limits the inspector's visibility to identify signs of pipe failure (leaks) along the slope. Recommend removing vegetation along pipe alignment to conduct proper inspection of structure. FIELD_STRUCT_DESC: 24-inch CM pipe through the levee, 8.0 feet below the crown. Flap gate on the waterward end. Brass cap No. 125 BM on headwall on the landward side. (USACE-1967). This entry matches the Drainage or Irrigation Structure referenced in O&M manual (HLM 7.77). FS Date: 5/1/2014

View of waterward side--photo taken from levee toe looking towards alignment of crossing.
