**Flood Control Project Maintenance
Levee Inspections**

Maintenance Issue Types Only, Levee Inspection Report By Mile - Spring 2017

Lower San Joaquin Levee District

Waterway	Bank	Unit Miles	Inspection Start/End	Inspector
Unit No. 01 San Joaquin River	Right	22.52	04/17/2017 04/20/2017	Richard Willoughby

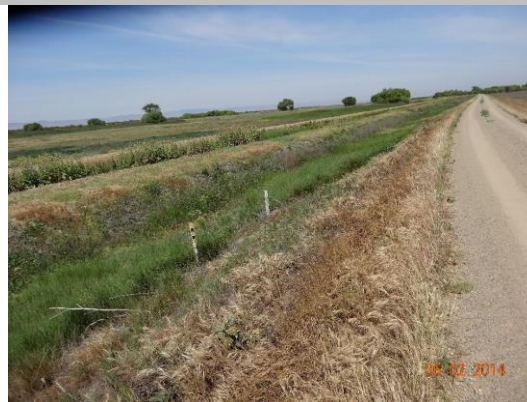
Photo 1 of 3 : UCIP_SP_2017_39366_66184.jpg

Comment Code					
Inspector Comment					
FS_ID:39366 DS_ID:19674 EP_NO: N/A Repair Type: Non-Urgent Crossing Status: Found UCIP Comments: Dense vegetation limits the inspector's visibility to identify signs of pipe failure (leaks) along the slope and landward headwall. Recommend removing vegetation along pipe alignment and toe to conduct proper inspection of structure. Sediment buildup in pipe visible from landward side--recommend clearing. FIELD_STRUCT_DESC: 24-inch CM pipe through the levee, 9.0 feet below the crown. Flap gate on the waterward end. Brass cap No. 120 BM on headwall on the landward side. (USACE-1967). This entry matches the Drainage or Irrigation Structure referenced in O&M manual (HLM 8.16). FS Date: 5/14/2014

View of landward side.

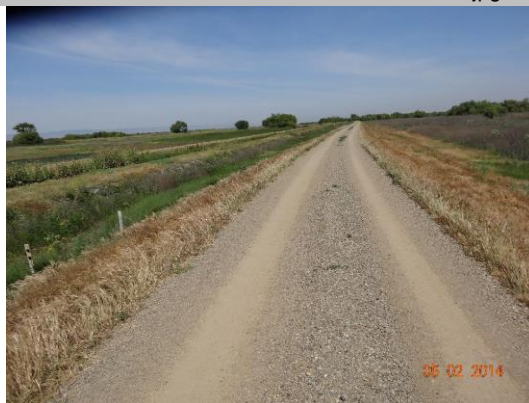
Photo 2 of 3 : UCIP_SP_2017_39366_66185.jpg

Comment Code					
Inspector Comment					
FS_ID:39366 DS_ID:19674 EP_NO: N/A Repair Type: Non-Urgent Crossing Status: Found UCIP Comments: Dense vegetation limits the inspector's visibility to identify signs of pipe failure (leaks) along the slope and landward headwall. Recommend removing vegetation along pipe alignment and toe to conduct proper inspection of structure. Sediment buildup in pipe visible from landward side--recommend clearing. FIELD_STRUCT_DESC: 24-inch CM pipe through the levee, 9.0 feet below the crown. Flap gate on the waterward end. Brass cap No. 120 BM on headwall on the landward side. (USACE-1967). This entry matches the Drainage or Irrigation Structure referenced in O&M manual (HLM 8.16). FS Date: 5/14/2014

Overview of levee crown at crossing.

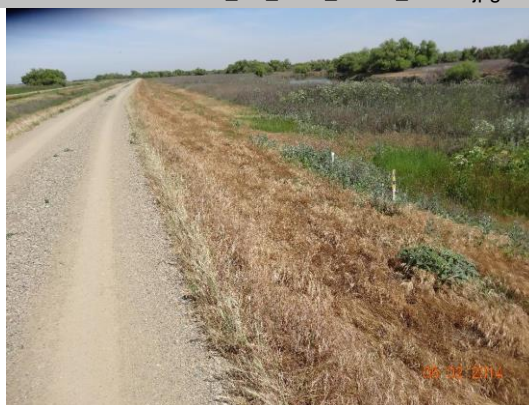
Photo 3 of 3 : UCIP_SP_2017_39366_66186.jpg

View of waterward side.

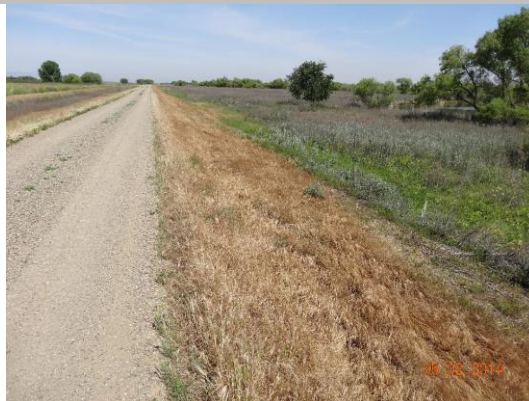
Photo 3 of 3 : UCIP_SP_2017_39367_66194.jpg

Comment Code					
Inspector Comment					
FS_ID:39367 DS_ID:19675 EP_NO: N/A Repair Type: Non-Urgent Crossing Status: Found UCIP Comments: Dense vegetation on landward toe. Also dense vegetation limits the inspector's visibility to identify signs of pipe failure (leaks) along waterward slope. Recommend removing vegetation along pipe alignment toe to conduct proper inspection of structure. Sediment buildup in pipe--recommend clearing. FIELD_STRUCT_DESC: 24-inch CM pipe through the levee, 9.4 feet below the crown. Flap gate on the waterward end. Brass cap No. 120 BM on headwall on the landward side. (USACE-1967). This entry matches the Drainage or Irrigation Structure referenced in O&M manual (HLM 8.48). FS Date: 5/14/2014

View of waterward side.

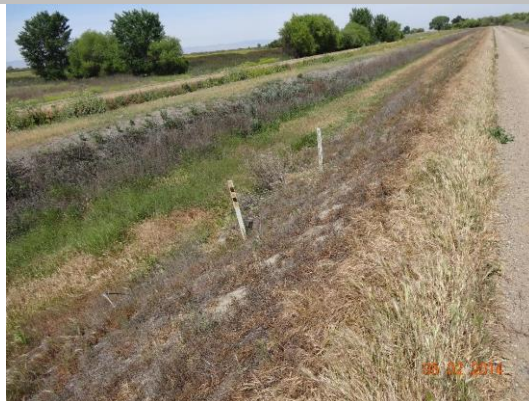
Photo 1 of 3 : UCIP_SP_2017_42503_66200.jpg

FS_ID:42503
DS_ID:19676
EP_NO: N/A
Repair Type: Non-Urgent
Crossing Status: Found
UCIP Comments: Dense vegetation limits the inspector's visibility to identify signs of pipe failure (leaks) along the slope. Recommend removing vegetation along pipe alignment to conduct proper inspection of structure. Burrow activity present on waterward slope.
FIELD_STRUCT_DESC: 24-inch CM pipe through the levee, 8.8 feet below the crown. Flap gate on the waterward end. Brass cap No. 120 BM on headwall on the landward side. (USACE-1967). This entry matches the Drainage or Irrigation Structure referenced in O&M manual (HLM 8.86).
FS Date: 5/14/2014

View of landward side.

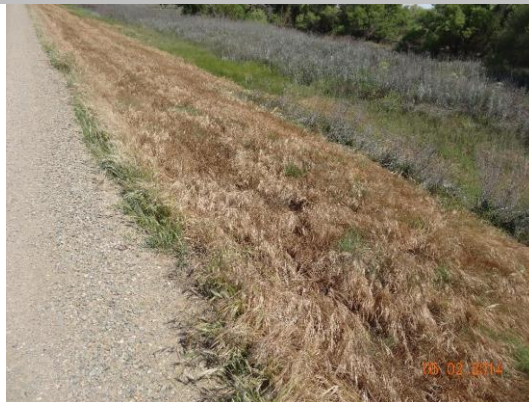
Photo 2 of 3 : UCIP_SP_2017_42503_66199.jpg

View of waterward side.

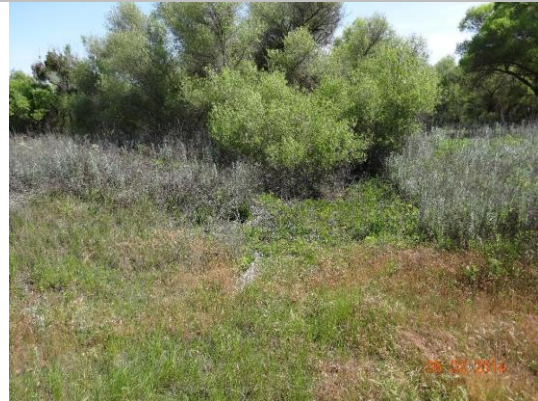
Photo 3 of 3 : UCIP_SP_2017_42503_66201.jpg

Comment Code					
Inspector Comment					
FS_ID:42503 DS_ID:19676 EP_NO: N/A Repair Type: Non-Urgent Crossing Status: Found UCIP Comments: Dense vegetation limits the inspector's visibility to identify signs of pipe failure (leaks) along the slope. Recommend removing vegetation along pipe alignment to conduct proper inspection of structure. Burrow activity presen on waterward slope. FIELD_STRUCT_DESC: 24-inch CM pipe through the levee, 8.8 feet below the crown. Flap gate on the waterward end. Brass cap No. 120 BM on headwall on the landward side. (USACE-1967). This entry matches the Drainage or Irrigation Structure referenced in O&M manual (HLM 8.86). FS Date: 5/14/2014

View of waterward toe.

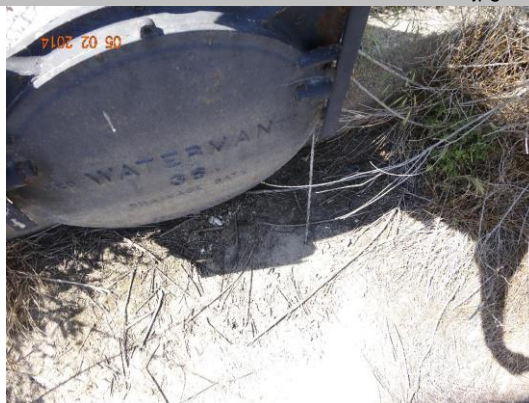
Photo 2 of 3 : UCIP_SP_2017_36525_66207.jpg

FS_ID:36525
DS_ID:19677
EP_NO: N/A
Repair Type: Non-Urgent
Crossing Status: Found
UCIP Comments: Dense vegetation limits the inspector's visibility to identify signs of pipe failure (leaks) along the slope. Recommend removing vegetation along pipe alignment to conduct proper inspection of structure.
FIELD_STRUCT_DESC: 36-inch CM pipe through the levee, 8.8 feet below the crown. Flap gate on the waterward end. Brass cap No. 120 BM on headwall on the landward side. (USACE-1967). This entry matches the Drainage or Irrigation Structure referenced in O&M manual (HLM 9.02).
FS Date: 5/14/2014

View of flap gate visible from waterward side.

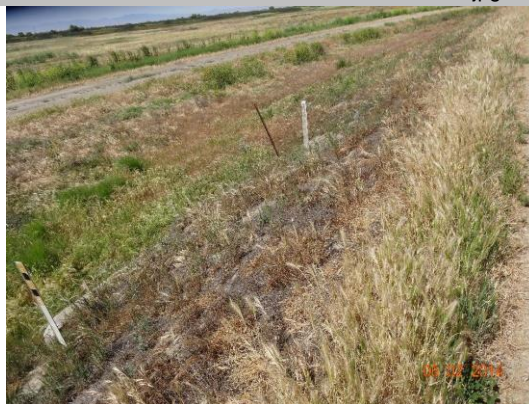
Photo 3 of 3 : UCIP_SP_2017_36525_66206.jpg

View of landward side.

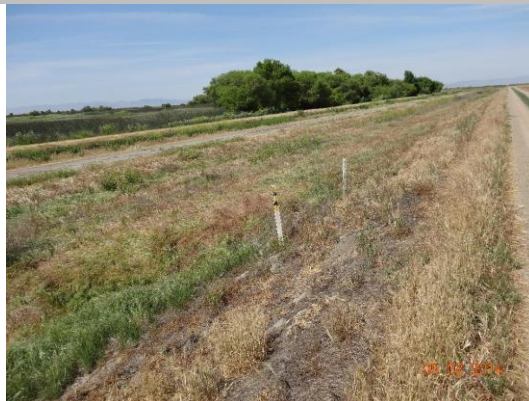
Photo 1 of 3 : UCIP_SP_2017_40443_66211.jpg

FS_ID:40443
DS_ID:19678
EP_NO: N/A
Repair Type: Non-Urgent
Crossing Status: Found
UCIP Comments: Dense vegetation limits the inspector's visibility to identify signs of pipe failure (leaks) along the slope. Recommend removing vegetation along pipe alignment to conduct proper inspection of structure.
FIELD_STRUCT_DESC: 24-inch CM pipe through the levee, 8.0 feet below the crown. Flap gate on the waterward end. Brass cap No. 120 BM on headwall on the landward side. (USACE-1967). This entry matches the Drainage or Irrigation Structure referenced in O&M manual (HLM 9.20).
FS Date: 5/14/2014

View of landward side.

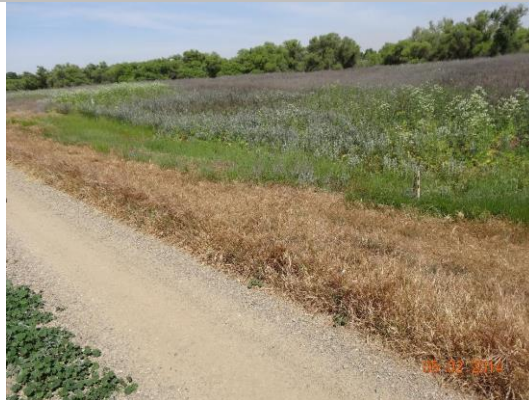
Photo 2 of 3 : UCIP_SP_2017_40443_66210.jpg

View of waterward side.

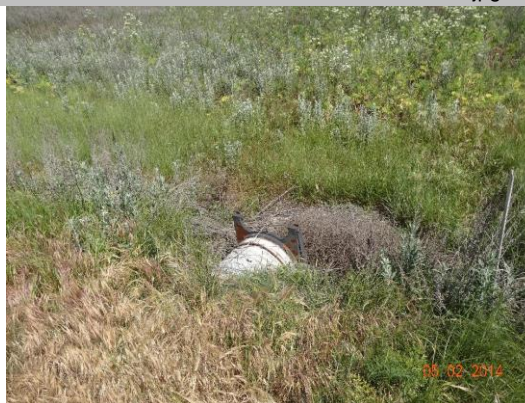
Photo 3 of 3 : UCIP_SP_2017_40443_66209.jpg

Item	DWR UCIP LMA Responsibility			37.220520 °		37.220520 °
				-120.793277 °		-120.793277 °
DWR ID						
Comment Code						
Inspector Comment						
FS_ID:40443						
DS_ID:19678						
EP_NO: N/A						
Repair Type: Non-Urgent						
Crossing Status: Found						
UCIP Comments: Dense vegetation limits the inspector's visibility to identify signs of pipe failure (leaks) along the slope. Recommend removing vegetation along pipe alignment to conduct proper inspection of structure.						
FIELD_STRUCT_DESC: 24-inch CM pipe through the levee, 8.0 feet below the crown. Flap gate on the waterward end. Brass cap No. 120 BM on headwall on the landward side. (USACE-1967). This entry matches the Drainage or Irrigation Structure referenced in O&M manual (HLM 9.20).						
FS Date: 5/14/2014

Pipe visible on waterward side.

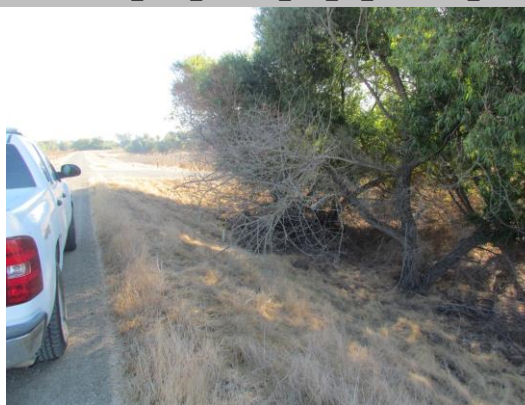
Photo 1 of 1 : SP_2017_NA0010_120_17_20170417_00005.jpg

LM Start	9.42	Rating **	M	Issue No.	17
LM End	9.42	Issue Type +	Ma	Location *	LS
Category	Earthen Levee			GPS Latitude/Longitude	
				Start	End
Item	Trim / Thin Trees			37.220199 °	37.220199 °
				-120.788748 °	-120.788748 °
DWR ID	DWR_NA0010_02B_f_2016_17				
Comment Code					
T1 : Trim trees to at least five feet above ground level.					
Inspector Comment					
Trim back dead tree limb on landward toe.

Looking at dead tree limb on landward slope.

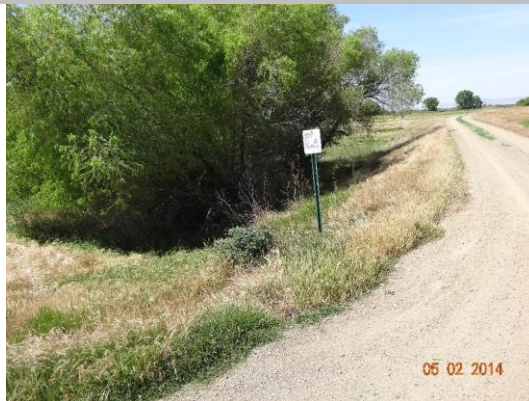
Photo 1 of 3 : UCIP_SP_2017_36527_66217.jpg

FS_ID:36527
DS_ID:19686
EP_NO: N/A
Repair Type: Non-Urgent
Crossing Status: Found
UCIP Comments: Dense vegetation limits the inspector's visibility to identify signs of pipe failure (leaks) along the slope. Recommend removing vegetation along pipe alignment to conduct proper inspection of structure.
FIELD_STRUCT_DESC: 24-inch CM pipe through the levee, 9.0 feet below the crown. Flap gate on the waterward end. Brass cap No. 115 BM on headwall on the landward side. (USACE-1967). This entry matches the Drainage or Irrigation Structure referenced in O&M manual (HLM 9.46).
FS Date: 5/14/2014

View of landward side.

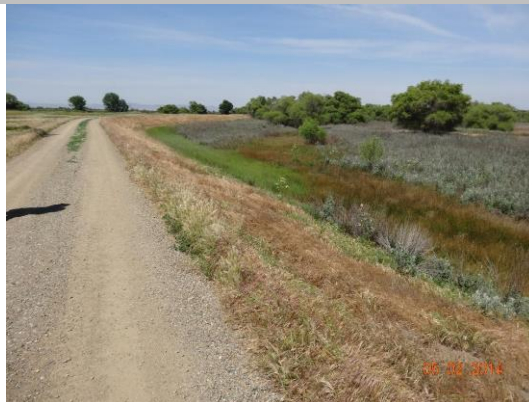
Photo 2 of 3 : UCIP_SP_2017_36527_66216.jpg

View of waterward side.

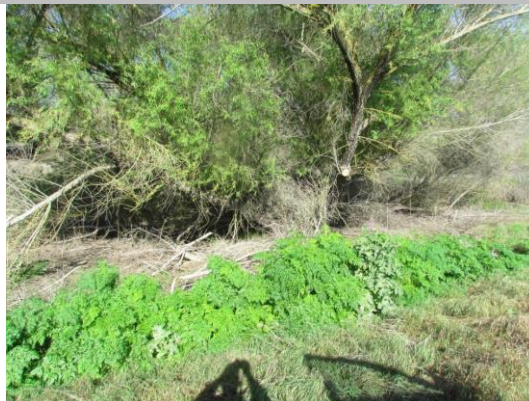
Photo 1 of 1 : SP_2017_NA0010_120_23_20170424_00009.jpg

LM Start	9.75	Rating **	U	Issue No.	23
LM End	9.75	Issue Type +	Ma	Location *	LS
Category	Earthen Levee			GPS Latitude/Longitude	
				Start	End
Item	Trim / Thin Trees			37.219083 °	37.219083 °
				-120.784327 °	-120.784327 °
DWR ID	DWR_NA0010_02B_s _ 2017_23				
Comment Code					
T1 : Trim trees to at least five feet above ground level.					
Inspector Comment

Looking west at untrimmed trees at landward toe.

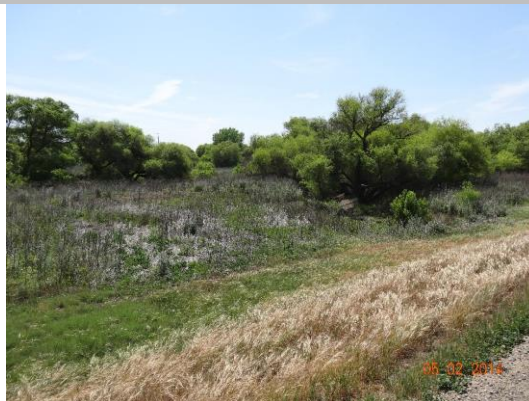
Photo 1 of 3 : UCIP_SP_2017_36528_66224.jpg

FS_ID:36528
DS_ID:19687
EP_NO: N/A
Repair Type: Non-Urgent
Crossing Status: Found
UCIP Comments: Dense vegetation limits the inspector's visibility to identify signs of pipe failure (leaks) along the slope. Recommend removing vegetation along pipe alignment to conduct proper inspection of structure.
FIELD_STRUCT_DESC: 24-inch CM pipe through the levee, 11.7 feet below the crown. Flap gate on the waterward end. Brass cap No. 115 BM on headwall on the landward side. (USACE-1967). This entry matches the Drainage or Irrigation Structure referenced in O&M manual (HLM 10.12).
FS Date: 5/14/2014

Overview of waterward side.

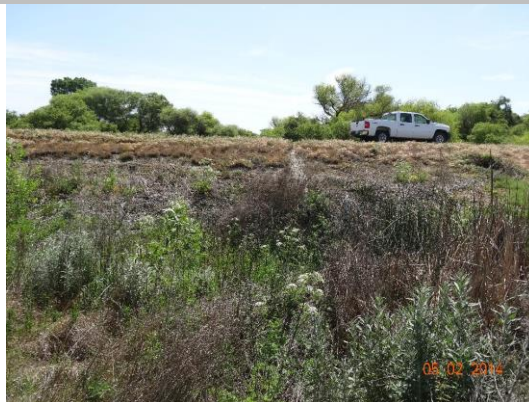
Photo 2 of 3 : UCIP_SP_2017_36528_66226.jpg

View of waterward slope.

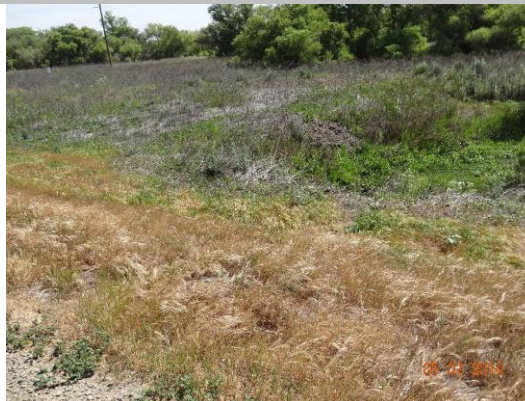
Photo 3 of 3 : UCIP_SP_2017_36528_66222.jpg

Item	DWR UCIP LMA Responsibility			37.214229 °	37.214229 °	
				-120.784350 °	-120.784350 °	
DWR ID						
Comment Code						
Inspector Comment						
FS_ID:36528						
DS_ID:19687						
EP_NO: N/A						
Repair Type: Non-Urgent						
Crossing Status: Found						
UCIP Comments: Dense vegetation limits the inspector's visibility to identify signs of pipe failure (leaks) along the slope. Recommend removing vegetation along pipe alignment to conduct proper inspection of structure.						
FIELD_STRUCT_DESC: 24-inch CM pipe through the levee, 11.7 feet below the crown. Flap gate on the waterward end. Brass cap No. 115 BM on headwall on the landward side. (USACE-1967). This entry matches the Drainage or Irrigation Structure referenced in O&M manual (HLM 10.12).						
FS Date: 5/14/2014

View of waterward side.

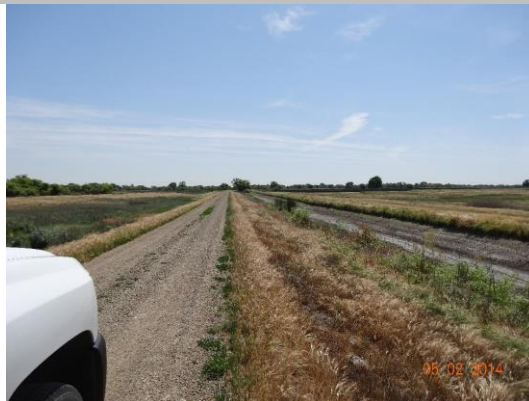
Photo 1 of 3 : UCIP_SP_2017_42504_66231.jpg

FS_ID:42504
DS_ID:19688
EP_NO: N/A
Repair Type: Non-Urgent
Crossing Status: Found
UCIP Comments: Dense vegetation limits the inspector's visibility to identify signs of pipe failure (leaks) along the slope. Recommend removing vegetation along pipe alignment to conduct proper inspection of structure. Sediment buildup in pipe visible on landward side-- recommend clearing.
FIELD_STRUCT_DESC: 24-inch CM pipe through the levee, 8.0 feet below the crown. Flap gate on the waterward end. Slide gate on the landward end. Brass cap No. 115 BM on headwall on the landward side. (USACE-1967). This entry matches the Drainage or Irrigation Structure referenced in O&M manual (HLM 10.81).
FS Date: 5/14/2014

View of landward side.

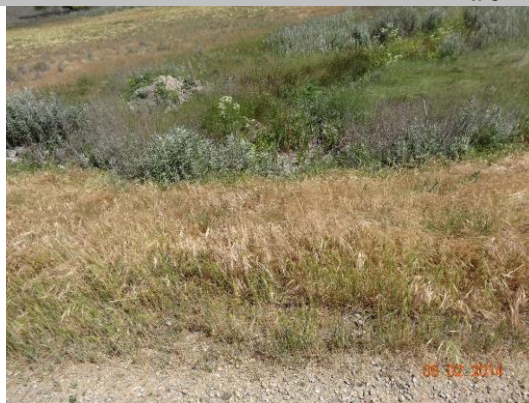
Photo 2 of 3 : UCIP_SP_2017_42504_66232.jpg

View of waterward side.

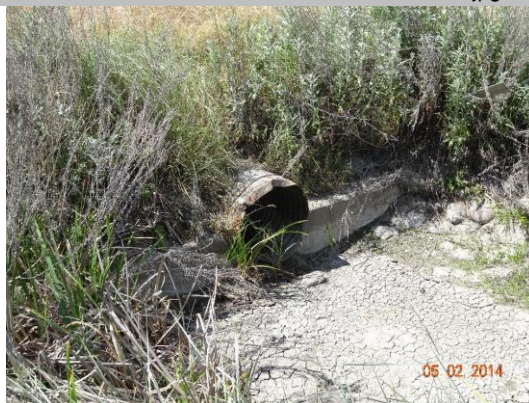
Photo 3 of 3 : UCIP_SP_2017_42504_66234.jpg

Comment Code					
Inspector Comment					
FS_ID:42504 DS_ID:19688 EP_NO: N/A Repair Type: Non-Urgent Crossing Status: Found UCIP Comments: Dense vegetation limits the inspector's visibility to identify signs of pipe failure (leaks) along the slope. Recommend removing vegetation along pipe alignment to conduct proper inspection of structure. Sediment buildup in pipe visible on landward side-- recommend clearing. FIELD_STRUCT_DESC: 24-inch CM pipe through the levee, 8.0 feet below the crown. Flap gate on the waterward end. Slide gate on the landward end. Brass cap No. 115 BM on headwall on the landward side. (USACE-1967). This entry matches the Drainage or Irrigation Structure referenced in O&M manual (HLM 10.81). FS Date: 5/14/2014

View of pipe visible on waterward side.

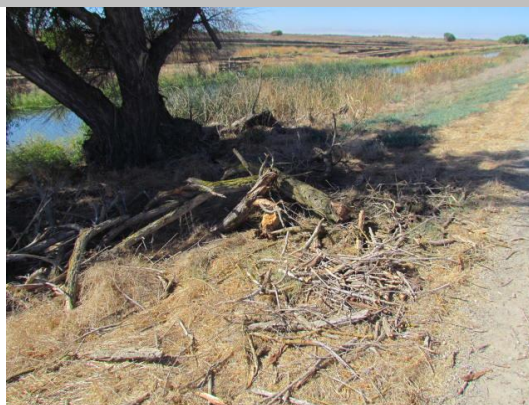
Photo 1 of 1 : SP_2017_NA0010_120_14_20170417_00004.jpg

LM Start	10.94	Rating **	M	Issue No.	14
LM End	10.94	Issue Type +	Ma	Location *	LS
Category	Earthen Levee			GPS Latitude/Longitude	
				Start	End
Item	Encroachments			37.205711 °	37.205711 °
				-120.774741 °	-120.774741 °
DWR ID	DWR_NA0010_02B_f_2015_14				
Comment Code					
PR : Prunings					
Inspector Comment					
Prunings on landward slope.

Looking at prunings on landward slope.

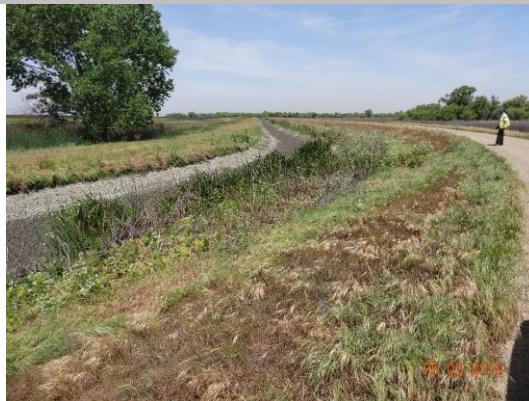
Photo 1 of 3 : UCIP_SP_2017_36531_66241.jpg

FS_ID:36531
DS_ID:19690
EP_NO: N/A
Repair Type: Non-Urgent
Crossing Status: Found
UCIP Comments: Dense vegetation limits the inspector's visibility to identify signs of pipe failure (leaks) along the slope. Recommend removing vegetation along pipe alignment to conduct proper inspection of structure.
FIELD_STRUCT_DESC: 24-inch CM pipe through the levee, 8.0 feet below the crown. Flap gate on the waterward end. Screw gate on the landward side. (USACE-1967). This entry matches the Drainage or Irrigation Structure referenced in O&M manual (HLM 11.43).
FS Date: 5/14/2014

View of landward side.

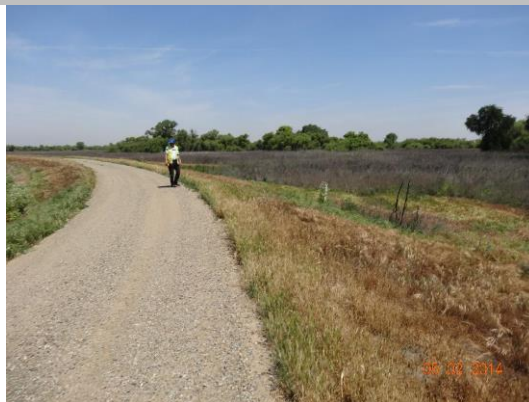
Photo 2 of 3 : UCIP_SP_2017_36531_66240.jpg

View of waterward side.

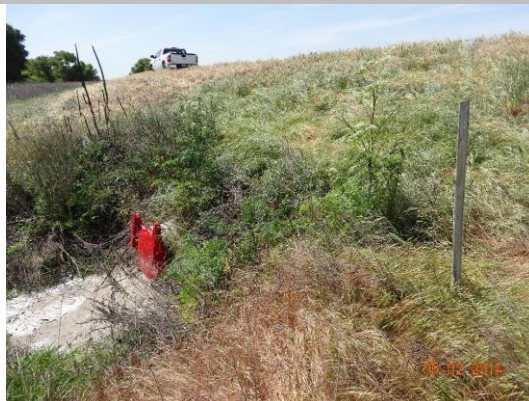
Photo 3 of 3 : UCIP_SP_2017_36531_66239.jpg

LM Start	11.40	Rating **	M	Issue No.	177 (cont)	
LM End	11.40	Issue Type +	Ma	Location *	LS	
Category	Supplemental			GPS Latitude/Longitude		
				Start		End
Item	DWR UCIP LMA Responsibility			37.201792 °		37.201792 °
				-120.768462 °		-120.768462 °
DWR ID						
Comment Code						
Inspector Comment						
FS_ID:36531 DS_ID:19690 EP_NO: N/A Repair Type: Non-Urgent Crossing Status: Found UCIP Comments: Dense vegetation limits the inspector's visibility to identify signs of pipe failure (leaks) along the slope. Recommend removing vegetation along pipe alignment to conduct proper inspection of structure. FIELD_STRUCT_DESC: 24-inch CM pipe through the levee, 8.0 feet below the crown. Flap gate on the waterward end. Screw gate on the landward side. (USACE-1967). This entry matches the Drainage or Irrigation Structure referenced in O&M manual (HLM 11.43). FS Date: 5/14/2014

Flap gate visible on waterward toe.

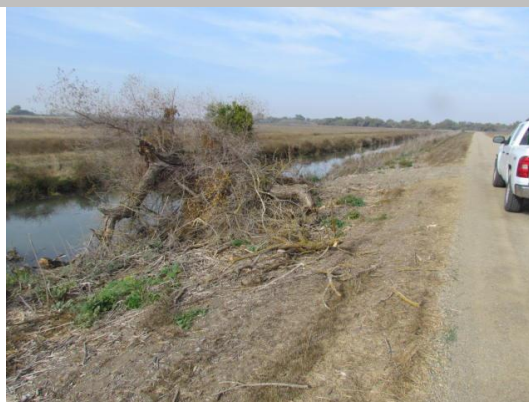
Photo 1 of 2 : SP_2017_NA0010_120_1_20170417_00001.jpg

LM Start	12.21	Rating **	M	Issue No.	1
LM End	12.21	Issue Type +	Ma	Location *	LS
Category	Earthen Levee			GPS Latitude/Longitude	
				Start	End
Item	Encroachments			37.191528 °	37.191528 °
				-120.764541 °	-120.764541 °
DWR ID	DWR_NA0010_02B_f_2014_1				
Comment Code					
TR : Tree or limb					
Inspector Comment					
Fallen tree limbs on landward slope.

Looking northwest at tree limb on waterward slope.

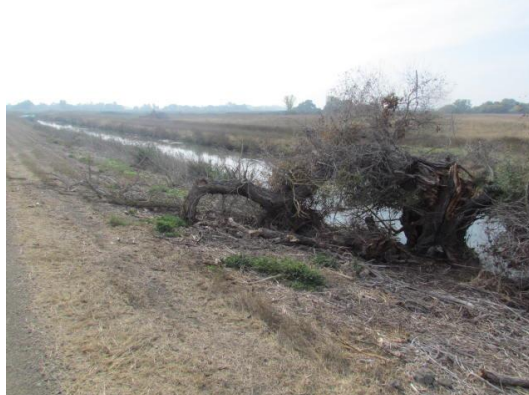
Photo 2 of 2 : SP_2017_NA0010_120_1_20170417_00002.jpg

LM Start	12.21	Rating **	M	Issue No.	1 (cont)	
LM End	12.21	Issue Type +	Ma	Location *	LS	
Category	Earthen Levee			GPS Latitude/Longitude		
				Start	End	
Item	Encroachments			37.191528 °	37.191528 °	
				-120.764541 °	-120.764541 °	
DWR ID	DWR_NA0010_02B_f_2014_1					
Comment Code						
TR : Tree or limb						
Inspector Comment						
Fallen tree limbs on landward slope.

Looking southwest at tree limb on waterward slope.

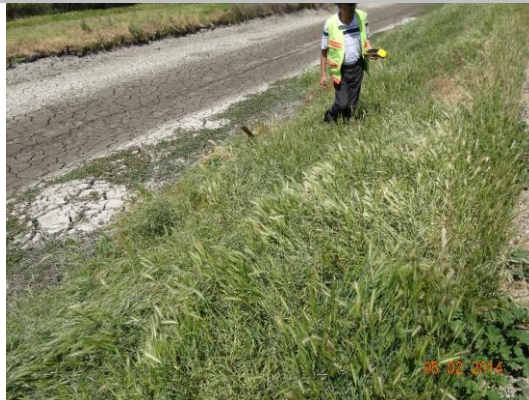
Photo 1 of 3 : UCIP_SP_2017_39370_66245.jpg

LM Start	13.18	Rating **	M	Issue No.	178
LM End	13.18	Issue Type +	Ma	Location *	LS
Category	Supplemental			GPS Latitude/Longitude	
				Start	End
Item	DWR UCIP LMA Responsibility			37.179265 °	37.179265 °
				-120.764870 °	-120.764870 °
DWR ID					
Comment Code					
Inspector Comment					
FS_ID:39370 DS_ID:19663 EP_NO: N/A Repair Type: Non-Urgent Crossing Status: Found UCIP Comments: Dense vegetation limits the inspector's visibility to identify signs of pipe failure (leaks) along the slope. Recommend removing vegetation along pipe alignment to conduct proper inspection of structure. Sediment buildup in pipe--recommend clearing. FIELD_STRUCT_DESC: 24-inch CM pipe through the levee, 6.5 feet below the crown. Slide gate in pipe riser on the waterward slope. (USACE-1967). This entry matches the Drainage or Irrigation Structure referenced in O&M manual (HLM 13.22). FS Date: 5/14/2014

View of landward side.

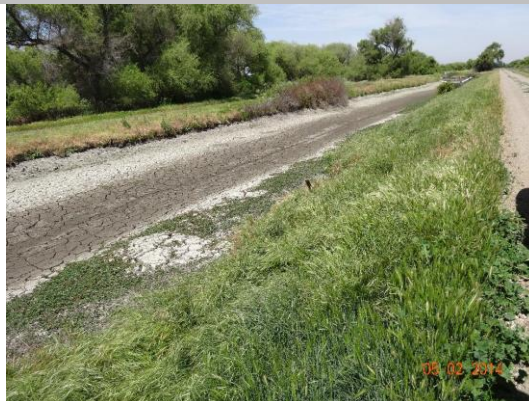
Photo 2 of 3 : UCIP_SP_2017_39370_66244.jpg

Comment Code					
Inspector Comment					
FS_ID:39370					
DS_ID:19663					
EP_NO: N/A					
Repair Type: Non-Urgent					
Crossing Status: Found					
UCIP Comments: Dense vegetation limits the inspector's visibility to identify signs of pipe failure (leaks) along the slope. Recommend removing vegetation along pipe alignment to conduct proper inspection of structure. Sediment buildup in pipe--recommend clearing.					
FIELD_STRUCT_DESC: 24-inch CM pipe through the levee, 6.5 feet below the crown. Slide gate in pipe riser on the waterward slope. (USACE-1967). This entry matches the Drainage or Irrigation Structure referenced in O&M manual (HLM 13.22).					
FS Date: 5/14/2014

Overview of landward slope.

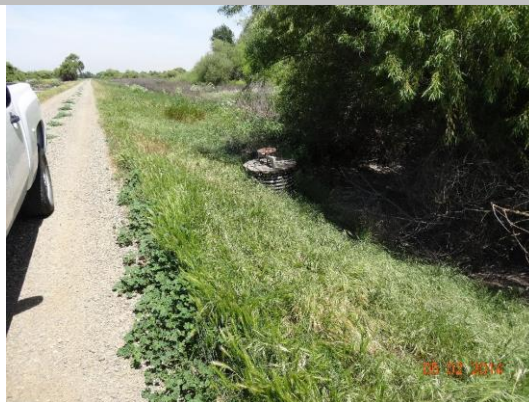
Photo 3 of 3 : UCIP_SP_2017_39370_66243.jpg

LM Start	13.18	Rating **	M	Issue No.	178 (cont)
LM End	13.18	Issue Type +	Ma	Location *	LS

View of waterward side.

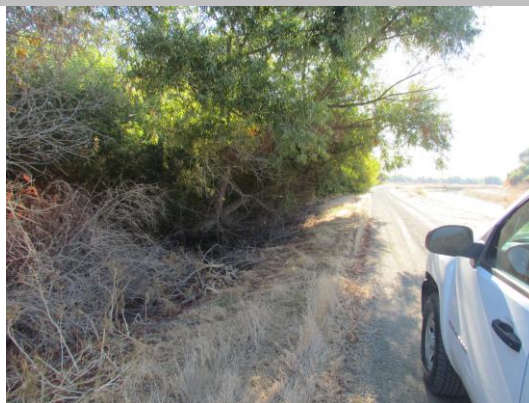
Photo 1 of 1 : SP_2017_NA0010_120_167_20170417_00008.jpg

LM Start	13.42	Rating **	U	Issue No.	167
LM End	13.42	Issue Type +	Ma	Location *	WS
Category	Earthen Levee			GPS Latitude/Longitude	
				Start	End
Item	Trim / Thin Trees			37.176379 °	37.176379 °
				-120.762255 °	-120.762255 °
DWR ID	DWR_NA0010_02B_s _ 2015_167				
Comment Code					
T3 : Trim and thin trees to allow visibility of the ground and room to flood fight.					
Inspector Comment					
Dense trees on waterward slope.

Looking south at untrimmed trees on waterward slope.

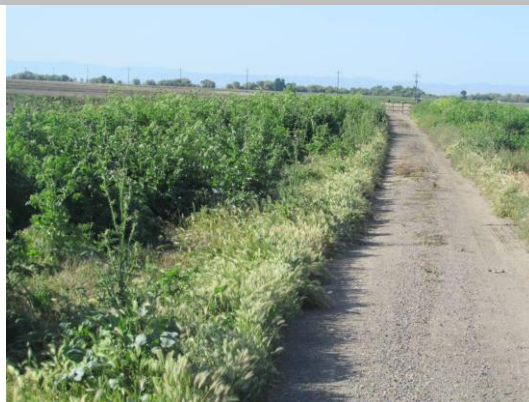
Photo 1 of 1 : SP_2017_NA0010_120_19_20170424_00011.jpg

LM Start	13.64	Rating **	U	Issue No.	19
LM End	13.75	Issue Type +	Ma	Location *	LS
Category	Earthen Levee			GPS Latitude/Longitude	
				Start	End
Item	Vegetation			37.173767 °	37.172157 °
				-120.761018 °	-120.761200 °
DWR ID	DWR_NA0010_02B_s _ 2017_19				
Comment Code					
V2 : Remove the wild growth other than native grasses from the levee slopes.					
Inspector Comment

Looking northwest at dense veg on landward slope.

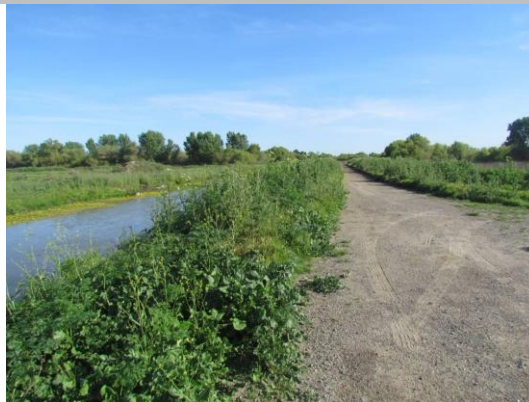
Photo 1 of 1 : SP_2017_NA0010_120_20_20170424_00010.jpg

LM Start	13.64	Rating **	U	Issue No.	20
LM End	13.75	Issue Type +	Ma	Location *	WS
Category	Earthen Levee			GPS Latitude/Longitude	
				Start	End
Item	Vegetation			37.173767 °	37.172157 °
				-120.761018 °	-120.761200 °
DWR ID	DWR_NA0010_02B_s _ 2017_20				
Comment Code					
V2 : Remove the wild growth other than native grasses from the levee slopes.					
Inspector Comment

Looking downstree at dense veg on waterward slope.

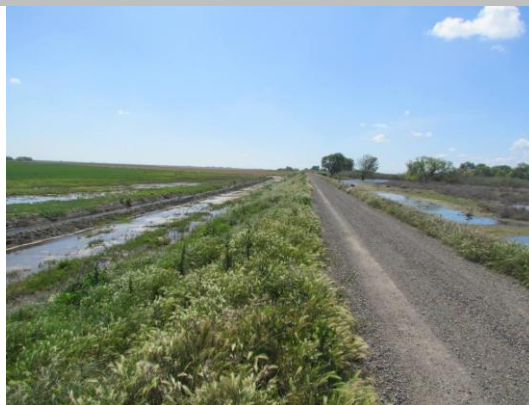
Photo 1 of 1 : SP_2017_NA0010_121_5_20170424_00014.jpg

LM Start	0.00	Rating **	M	Issue No.	5
LM End	2.09	Issue Type +	Ma	Location *	LS
Category	Earthen Levee			GPS Latitude/Longitude	
				Start	End
Item	Vegetation			37.111742 °	37.089017 °
				-120.587550 °	-120.566927 °
DWR ID	DWR_NA0010_03_s _ 2017_5				
Comment Code					
V1 : Control annual grass and weeds on the levee slopes and easements.					
Inspector Comment

Looking at typical view of landward slope.

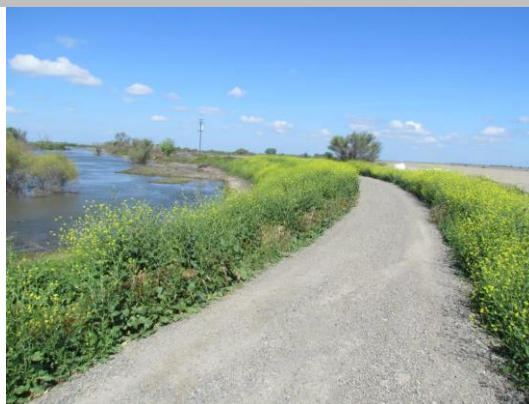
Photo 1 of 1 : SP_2017_NA0010_121_6_20170424_00013.jpg

LM Start	0.00	Rating **	M	Issue No.	6
LM End	2.09	Issue Type +	Ma	Location *	WS
Category	Earthen Levee			GPS Latitude/Longitude	
				Start	End
Item	Vegetation			37.111742 °	37.089017 °
				-120.587550 °	-120.566927 °
DWR ID	DWR_NA0010_03_s _ 2017_6				
Comment Code					
V1 : Control annual grass and weeds on the levee slopes and easements.					
Inspector Comment

Looking typical veiw of waterward slope.

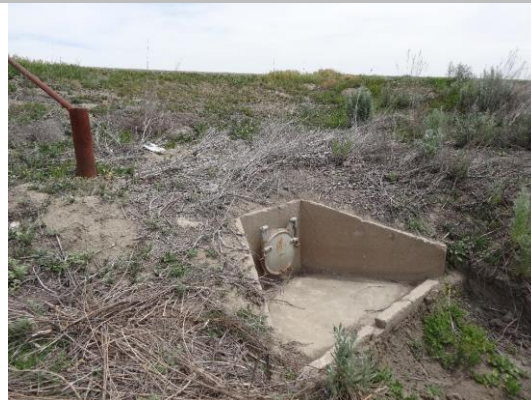
Photo 1 of 3 : UCIP_SP_2017_34083_61941.jpg

LM Start	0.42	Rating **	M	Issue No.	68
LM End	0.42	Issue Type +	Ma	Location *	LS
Category	Supplemental			GPS Latitude/Longitude	
				Start	End
Item	DWR UCIP LMA Responsibility			37.106233 °	37.106233 °
				-120.585797 °	-120.585797 °
DWR ID					
Comment Code					
Inspector Comment					
FS_ID:34083 DS_ID:19691 EP_NO: N/A Repair Type: Non-Urgent Crossing Status: Found UCIP Comments: Need to contact owner. Recommend removing tall grass on landward slope and clearing sediment build up inside pipe. FIELD_STRUCT_DESC: 24-inch CM pipe through the levee, 11.3 feet below the crown. Flap gate on the waterward end. (USACE-1967). This entry matches the Drainage or Irrigation Structure referenced in O&M manual (HLM 0.43). FS Date: 4/17/2014

Concrete structure and flap gate visible on waterward side.

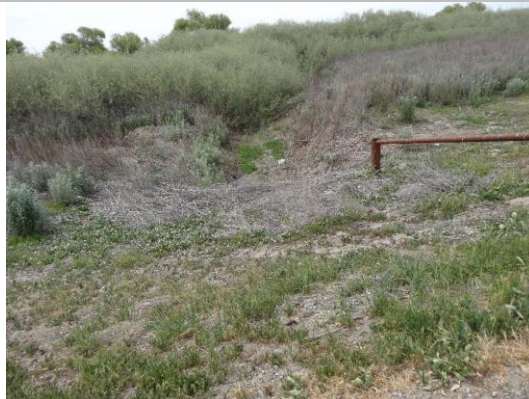
Photo 2 of 3 : UCIP_SP_2017_34083_61940.jpg

LM Start	0.42	Rating **	M	Issue No.	68 (cont)	
LM End	0.42	Issue Type +	Ma	Location *	LS	
Category	Supplemental			GPS Latitude/Longitude		
				Start	End	
Item	DWR UCIP LMA Responsibility			37.106233 °	37.106233 °	
				-120.585797 °	-120.585797 °	
DWR ID						
Comment Code						
Inspector Comment						
FS_ID:34083						
DS_ID:19691						
EP_NO: N/A						
Repair Type: Non-Urgent						
Crossing Status: Found						
UCIP Comments: Need to contact owner. Recommend removing tall grass on landward slope and clearing sediment build up inside pipe.						
FIELD_STRUCT_DESC: 24-inch CM pipe through the levee, 11.3 feet below the crown. Flap gate on the waterward end. (USACE-1967). This entry matches the Drainage or Irrigation Structure referenced in O&M manual (HLM 0.43).						
FS Date: 4/17/2014

View of waterward side.

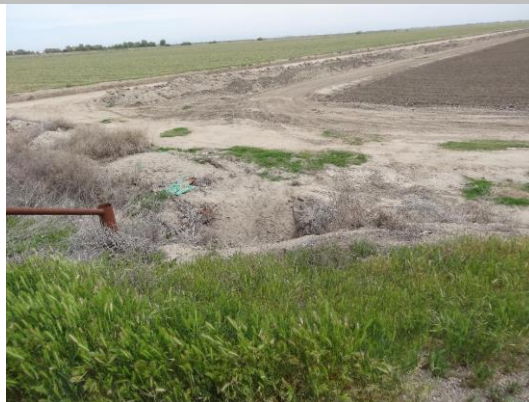
Photo 3 of 3 : UCIP_SP_2017_34083_61944.jpg

LM Start	0.42	Rating **	M	Issue No.	68 (cont)
LM End	0.42	Issue Type +	Ma	Location *	LS

View of landward side.

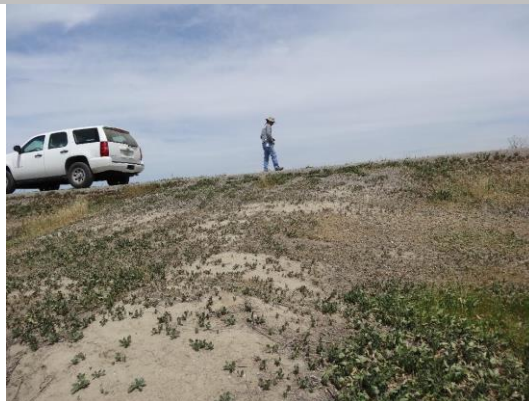
Photo 1 of 3 : UCIP_SP_2017_36534_66248.jpg

LM Start	0.76	Rating **	A/W	Issue No.	69
LM End	0.76	Issue Type +	Ma	Location *	LS
Category	Supplemental			GPS Latitude/Longitude	
				Start	End
Item	DWR UCIP LMA Responsibility			37.102964 °	37.102964 °
				-120.581421 °	-120.581421 °
DWR ID					
Comment Code					
Inspector Comment					
FS_ID:36534 DS_ID:19692 EP_NO: N/A Repair Type: No Action Needed Crossing Status: Found UCIP Comments: FIELD_STRUCT_DESC: 24-inch CM pipe through the levee, 9.3 feet below the crown. Flap gate on the waterward end. (USACE-1967). This entry matches the Drainage or Irrigation Structure referenced in O&M manual (HLM 0.77). FS Date: 4/17/2014

View of waterward slope.

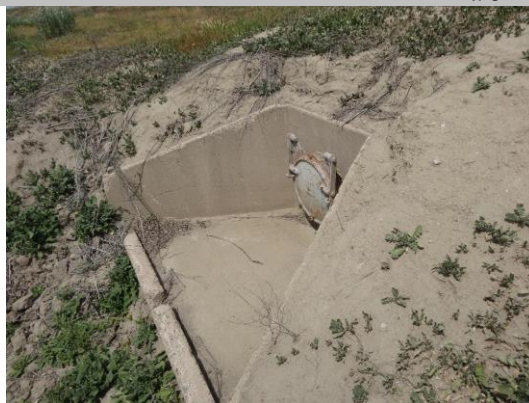
Photo 2 of 3 : UCIP_SP_2017_36534_66249.jpg

Concrete structure located on waterward side.

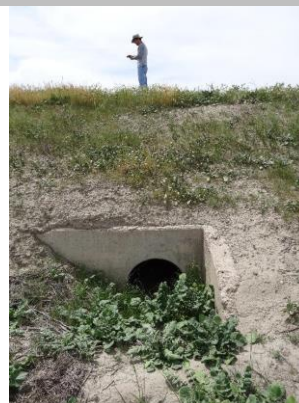
Photo 3 of 3 : UCIP_SP_2017_36534_66251.jpg

LM Start	0.76	Rating **	A/W	Issue No.	69 (cont)	
LM End	0.76	Issue Type +	Ma	Location *	LS	
Category	Supplemental			GPS Latitude/Longitude		
				Start	End	
Item	DWR UCIP LMA Responsibility			37.102964 °	37.102964 °	
				-120.581421 °	-120.581421 °	
DWR ID						
Comment Code						
Inspector Comment						
FS_ID:36534						
DS_ID:19692						
EP_NO: N/A						
Repair Type: No Action Needed						
Crossing Status: Found						
UCIP Comments:						
FIELD_STRUCT_DESC: 24-inch CM pipe through the levee, 9.3 feet below the crown. Flap gate on the waterward end. (USACE-1967). This entry matches the Drainage or Irrigation Structure referenced in O&M manual (HLM 0.77).						
FS Date: 4/17/2014

View of landward slope.

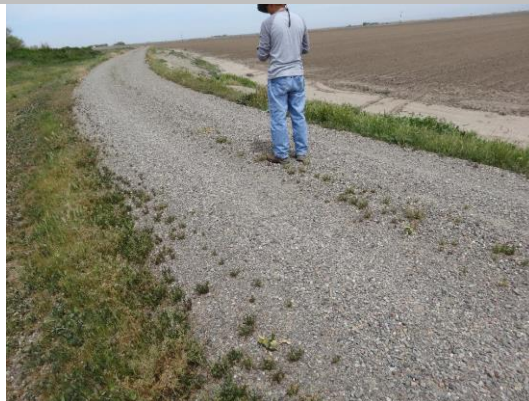
Photo 1 of 3 : UCIP_SP_2017_39371_66252.jpg

LM Start	1.71	Rating **	M	Issue No.	70
LM End	1.71	Issue Type +	Ma	Location *	LS
Category	Supplemental			GPS Latitude/Longitude	
				Start	End
Item	DWR UCIP LMA Responsibility			37.092079 °	37.092079 °
				-120.572316 °	-120.572316 °
DWR ID					
Comment Code					
Inspector Comment					
FS_ID:39371					
DS_ID:19693					
EP_NO: N/A					
Repair Type: Non-Urgent					
Crossing Status: Found					
UCIP Comments: Sediment buildup in pipe visible from landward side--recommend clearing.					
FIELD_STRUCT_DESC: 24-inch CM pipe through the levee, 6.8 feet below the crown. Flap gate on the waterward end. (USACE-1967). This entry matches the Drainage or Irrigation Structure referenced in O&M manual (HLM 1.72).					
FS Date: 4/17/2014

View of levee crown at crossing.

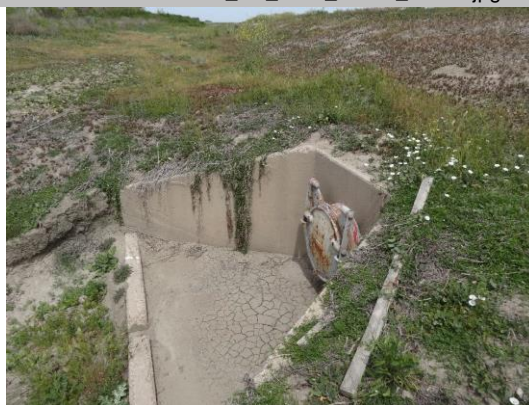
Photo 2 of 3 : UCIP_SP_2017_39371_66254.jpg

Concrete structure located on waterward side.

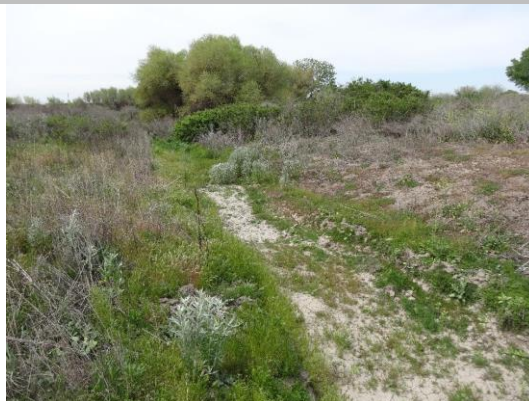
Photo 3 of 3 : UCIP_SP_2017_39371_66253.jpg

LM Start	1.71	Rating **	M	Issue No.	70 (cont)	
LM End	1.71	Issue Type +	Ma	Location *	LS	
Category	Supplemental			GPS Latitude/Longitude		
				Start		End
Item	DWR UCIP LMA Responsibility			37.092079 °		37.092079 °
				-120.572316 °		-120.572316 °
DWR ID						
Comment Code						
Inspector Comment						
FS_ID:39371 DS_ID:19693 EP_NO: N/A Repair Type: Non-Urgent Crossing Status: Found UCIP Comments: Sediment buildup in pipe visible from landward side--recommend clearing. FIELD_STRUCT_DESC: 24-inch CM pipe through the levee, 6.8 feet below the crown. Flap gate on the waterward end. (USACE-1967). This entry matches the Drainage or Irrigation Structure referenced in O&M manual (HLM 1.72). FS Date: 4/17/2014

View of waterward side--channel.

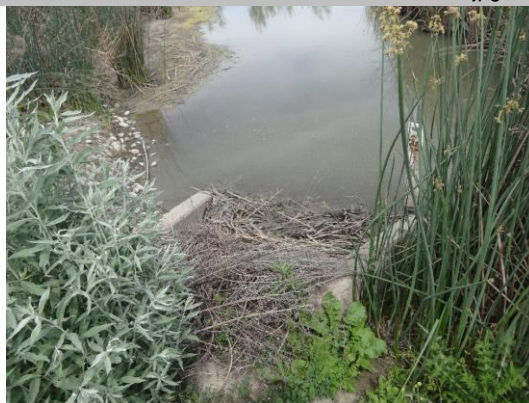
Photo 1 of 3 : UCIP_SP_2017_34093_61982.jpg

FS_ID:34093
DS_ID:19695
EP_NO: N/A
Repair Type: Non-Urgent
Crossing Status: Found
UCIP Comments: Sediment and debris blocking concrete headwall located on waterward side. During inspection water was flowing from landward side to waterward side. Recommend removing sediment to confirm condition of flap gate and pipe.
FIELD_STRUCT_DESC: 36-inch CM pipe through the levee, 18.0 feet below the crown. Flap gate on the waterward end. Concrete headwalls on both sides. (USACE-1967). This entry matches the Drainage or Irrigation Structure referenced in O&M manual (HLM 0.27).
FS Date: 4/17/2014

View of dense vegetation near concrete headwall located on waterward side.

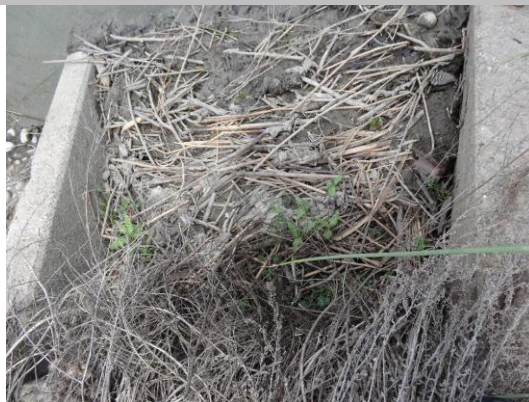
Photo 2 of 3 : UCIP_SP_2017_34093_61981.jpg

Sediment blocking flap gate located on waterward side.

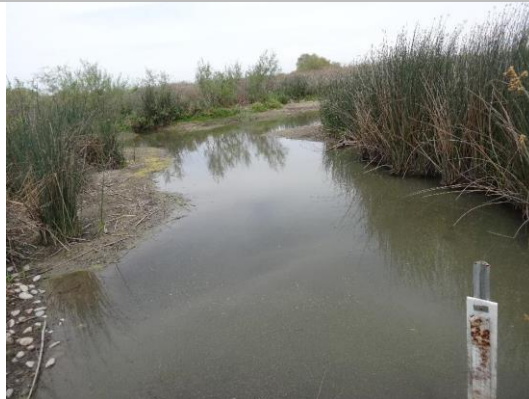
Photo 3 of 3 : UCIP_SP_2017_34093_61980.jpg

LM Start	0.24	Rating **	M	Issue No.	14 (cont)
LM End	0.24	Issue Type +	Ma	Location *	WS
Category	Supplemental			GPS Latitude/Longitude	
				Start	End
Item	DWR UCIP LMA Responsibility			37.109933 °	37.109933 °
				-120.590689 °	-120.590689 °
DWR ID					
Comment Code					
Inspector Comment					
FS_ID:34093 DS_ID:19695 EP_NO: N/A Repair Type: Non-Urgent Crossing Status: Found UCIP Comments: Sediment and debris blocking concrete headwall located on waterward side. During inspection water was flowing from landward side to waterward side. Recommend removing sediment to confirm condition of flap gate and pipe. FIELD_STRUCT_DESC: 36-inch CM pipe through the levee, 18.0 feet below the crown. Flap gate on the waterward end. Concrete headwalls on both sides. (USACE-1967). This entry matches the Drainage or Irrigation Structure referenced in O&M manual (HLM 0.27). FS Date: 4/17/2014

View of waterward side.

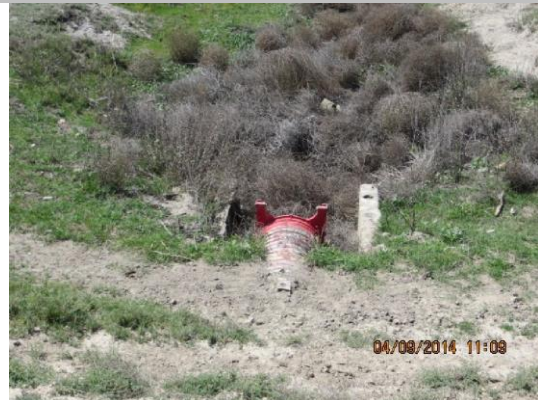
Photo 1 of 3 : UCIP_SP_2017_39563_60921.jpg

LM Start	0.08	Rating **	M	Issue No.	1311
LM End	0.08	Issue Type +	Ma	Location *	LS
Category	Supplemental			GPS Latitude/Longitude	
				Start	End
Item	DWR UCIP LMA Responsibility			37.278174 °	37.278174 °
				-120.823465 °	-120.823465 °
DWR ID					
Comment Code					
Inspector Comment					
FS_ID:39563 DS_ID:19756 EP_NO: N/A Repair Type: Non-Urgent Crossing Status: Found UCIP Comments: Debris blocking landward headwall--recommend clearing. FIELD_STRUCT_DESC: 24-inch C.M. stormdrain pipe through the levee, 8.6 feet below the crown. Flap gate on the waterward end. Concrete headwall on the landward end. Concrete "U" headwall on the waterward end. (USACE-1967). This entry matches the Drainage or Irrigation Structure referenced in O&M manual (HLM 0.07). FS Date: 4/9/2014

Pipe, flapgate, and concrete headwall on WS toe.

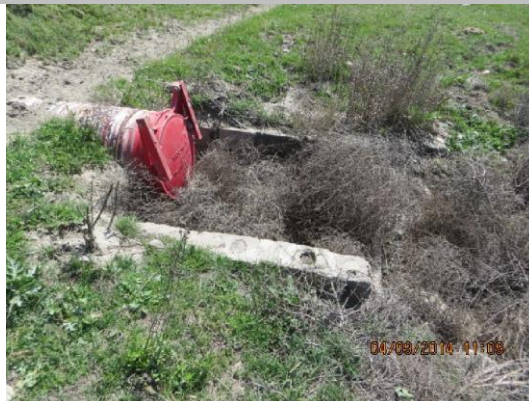
Photo 2 of 3 : UCIP_SP_2017_39563_60920.jpg

LM Start	0.08	Rating **	M	Issue No.	1311 (cont)
LM End	0.08	Issue Type +	Ma	Location *	LS
Category	Supplemental			GPS Latitude/Longitude	
				Start	End
Item	DWR UCIP LMA Responsibility			37.278174 °	37.278174 °
				-120.823465 °	-120.823465 °
DWR ID					
Comment Code					
Inspector Comment					
FS_ID:39563 DS_ID:19756 EP_NO: N/A Repair Type: Non-Urgent Crossing Status: Found UCIP Comments: Debris blocking landward headwall--recommend clearing. FIELD_STRUCT_DESC: 24-inch C.M. stormdrain pipe through the levee, 8.6 feet below the crown. Flap gate on the waterward end. Concrete headwall on the landward end. Concrete "U" headwall on the waterward end. (USACE-1967). This entry matches the Drainage or Irrigation Structure referenced in O&M manual (HLM 0.07). FS Date: 4/9/2014

Pipe, flapgate, and concrete headwall on WS toe.

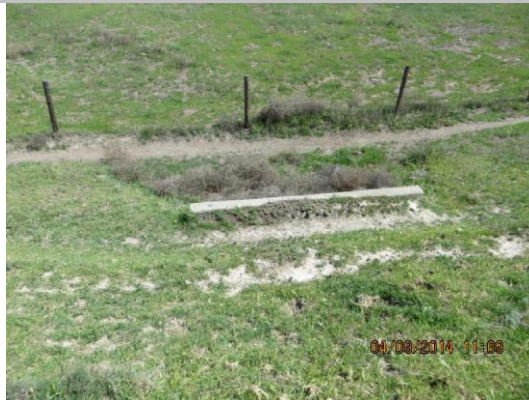
Photo 3 of 3 : UCIP_SP_2017_39563_60922.jpg

Pipe and concrete headwall on LS toe.

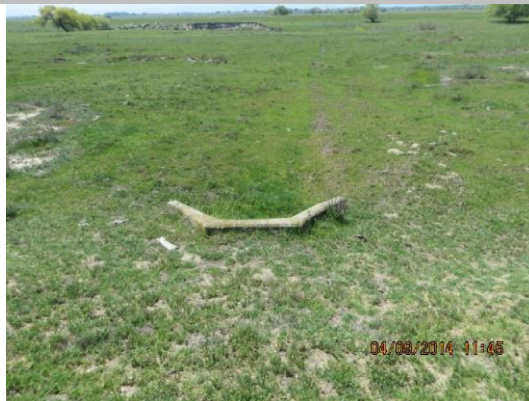
Photo 1 of 3 : UCIP_SP_2017_39584_60926.jpg

LM Start	0.60	Rating **	M	Issue No.	1313
LM End	0.60	Issue Type +	Ma	Location *	LS
Category	Supplemental			GPS Latitude/Longitude	
				Start	End
Item	DWR UCIP LMA Responsibility			37.273945 °	37.273945 °
				-120.815835 °	-120.815835 °
DWR ID					
Comment Code					
Inspector Comment					
FS_ID:39584 DS_ID:19757 EP_NO: N/A Repair Type: Non-Urgent Crossing Status: Found UCIP Comments: Excess debris on landward headwall--recommend clearing. FIELD_STRUCT_DESC: 30-inch C.M. stormdrain pipe through the levee, 7.5 feet below the crown. Flap gate on the waterward end. Concrete headwall on the landward end. Concrete "U" headwall on the waterward end. (USACE-1967). This entry matches the Drainage or Irrigation Structure referenced in O&M manual (HLM 0.59). FS Date: 4/9/2014

Concrete headwall, pipe, and flapgate on WS toe.

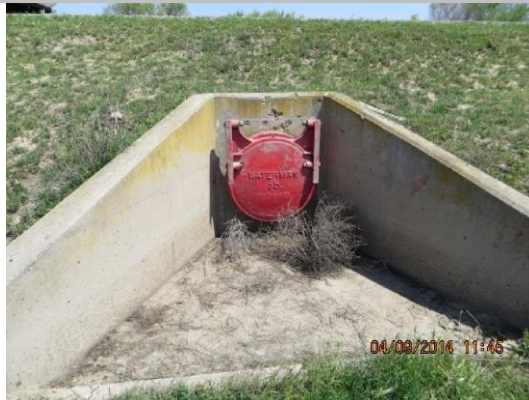
Photo 2 of 3 : UCIP_SP_2017_39584_60925.jpg

Concrete headwall, pipe, and flapgate on WS toe.

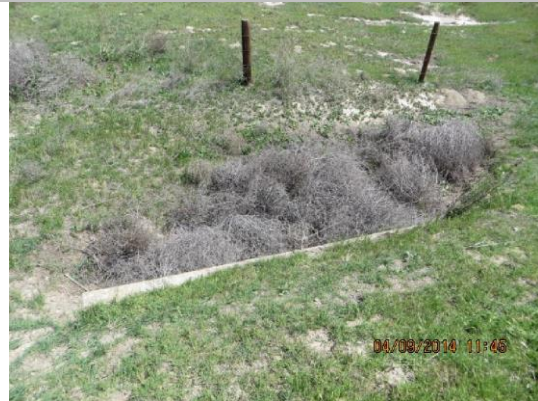
Photo 3 of 3 : UCIP_SP_2017_39584_60927.jpg

LM Start	0.60	Rating **	M	Issue No.	1313 (cont)	
LM End	0.60	Issue Type +	Ma	Location *	LS	
Category	Supplemental			GPS Latitude/Longitude		
				Start	End	
Item	DWR UCIP LMA Responsibility			37.273945 °	37.273945 °	
				-120.815835 °	-120.815835 °	
DWR ID						
Comment Code						
Inspector Comment						
FS_ID:39584 DS_ID:19757 EP_NO: N/A Repair Type: Non-Urgent Crossing Status: Found UCIP Comments: Excess debris on landward headwall--recommend clearing. FIELD_STRUCT_DESC: 30-inch C.M. stormdrain pipe through the levee, 7.5 feet below the crown. Flap gate on the waterward end. Concrete headwall on the landward end. Concrete "U" headwall on the waterward end. (USACE-1967). This entry matches the Drainage or Irrigation Structure referenced in O&M manual (HLM 0.59). FS Date: 4/9/2014

Pipe and concrete headwall on LS toe. Note vegetation buildup.

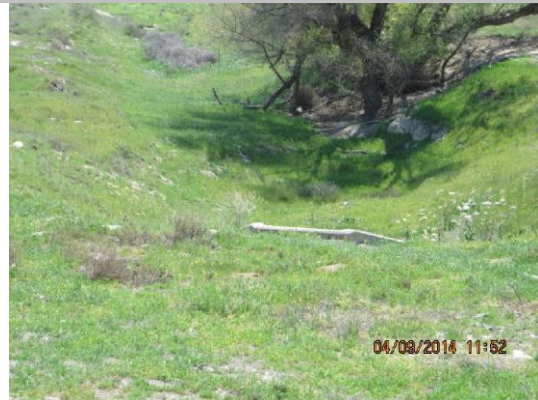
Photo 1 of 3 : UCIP_SP_2017_39585_60931.jpg

Comment Code					
Inspector Comment					
FS_ID:39585 DS_ID:19758 EP_NO: N/A Repair Type: Non-Urgent Crossing Status: Found UCIP Comments: Dense vegetation limits the inspector's visibility to identify signs of pipe failure (leaks) along the landward slope. Recommend removing vegetation along pipe alignment to conduct proper inspection of structure. FIELD_STRUCT_DESC: 36-inch C.M. stormdrain pipe through the levee, 13.2 feet below the crown. Flap gate on the waterward end. Concrete headwall on the landward end. Concrete "U" headwall on the waterward end. Cobble revetment around both ends. (USACE-1967). This entry matches the Drainage or Irrigation Structure referenced in O&M manual (HLM 0.65). FS Date: 4/9/2014

Concrete headwall visible off WS toe.

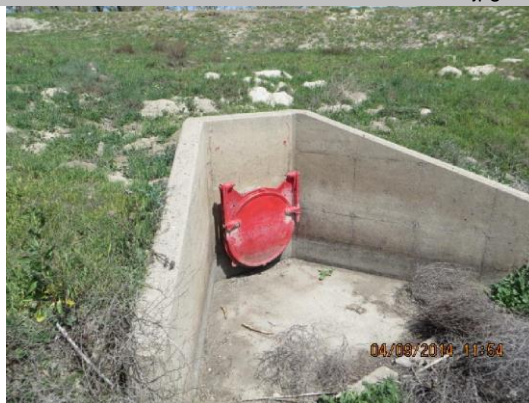
Photo 2 of 3 : UCIP_SP_2017_39585_60929.jpg

Item	DWR UCIP LMA Responsibility			37.273398 °	37.273398 °	
				-120.815082 °	-120.815082 °	
DWR ID						
Comment Code						
Inspector Comment						
FS_ID:39585						
DS_ID:19758						
EP_NO: N/A						
Repair Type: Non-Urgent						
Crossing Status: Found						
UCIP Comments: Dense vegetation limits the inspector's visibility to identify signs of pipe failure (leaks) along the landward slope.						
Recommend removing vegetation along pipe alignment to conduct proper inspection of structure.						
FIELD_STRUCT_DESC: 36-inch C.M. stormdrain pipe through the levee, 13.2 feet below the crown. Flap gate on the waterward end. Concrete headwall on the landward end. Concrete "U" headwall on the waterward end. Cobble revetment around both ends. (USACE-1967). This entry matches the Drainage or Irrigation Structure referenced in O&M manual (HLM 0.65).						
FS Date: 4/9/2014

Pipe, flapgate, and headwall at WS toe.

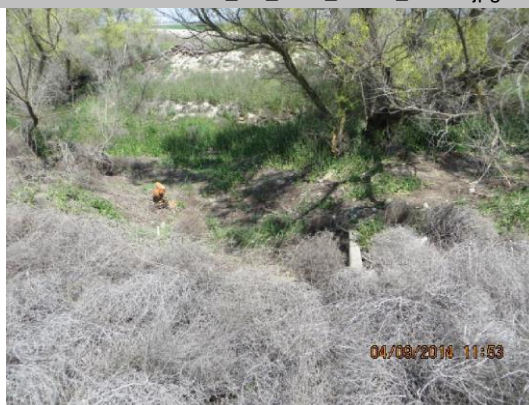
Photo 3 of 3 : UCIP_SP_2017_39585_60930.jpg

Concrete headwall at LS toe.

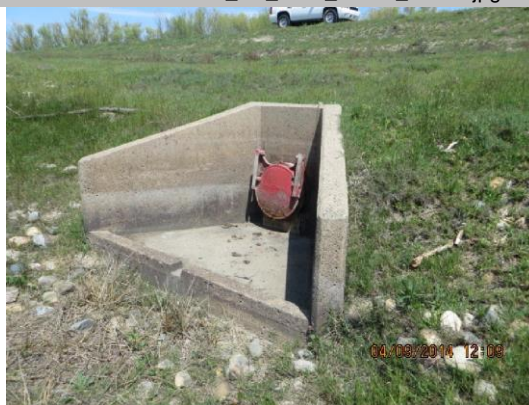
Photo 2 of 3 : UCIP_SP_2017_33707_60933.jpg

Pipe, flapgate, and headwall at WS toe.

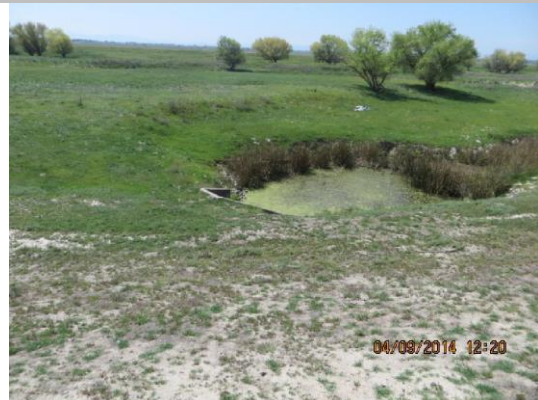
Photo 1 of 3 : UCIP_SP_2017_33708_60939.jpg

LM Start	1.45	Rating **	A/W	Issue No.	1316
LM End	1.45	Issue Type +	Ma	Location *	LS
Category	Supplemental			GPS Latitude/Longitude	
				Start	End
Item	DWR UCIP LMA Responsibility			37.265804 °	37.265804 °
				-120.804955 °	-120.804955 °
DWR ID					
Comment Code					
Inspector Comment					
FS_ID:33708					
DS_ID:19760					
EP_NO: N/A					
Repair Type: No Action Needed					
Crossing Status: Found					
UCIP Comments:					
FIELD_STRUCT_DESC: 36-inch C.M. stormdrain pipe through the levee, 21.0 feet below the crown. Flap gate on the waterward end. Concrete headwall on the landward end. Concrete "U" headwall on the waterward end. (USACE-1967). This entry matches the Drainage or Irrigation Structure referenced in O&M manual (HLM 1.44).					
FS Date: 4/9/2014

Flapgate on concrete headwall at WS toe.

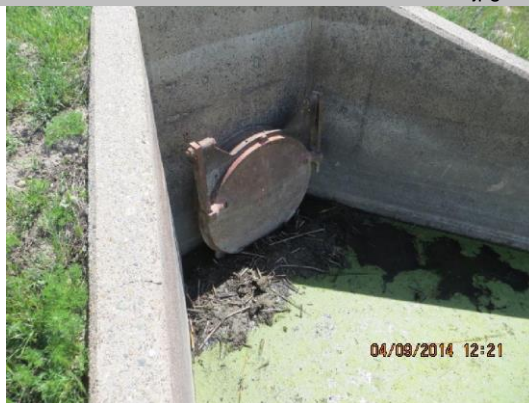
Photo 2 of 3 : UCIP_SP_2017_33708_60938.jpg

Flapgate on concrete headwall at WS toe.

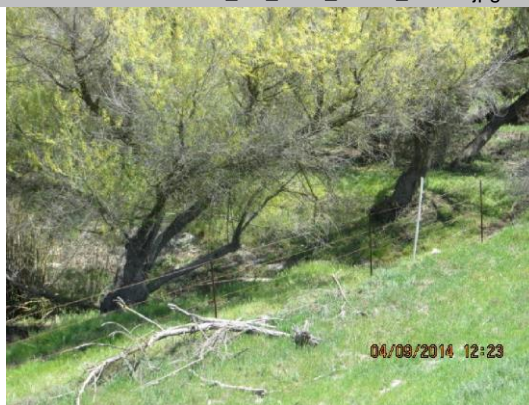
Photo 3 of 3 : UCIP_SP_2017_33708_60937.jpg

Pipe and concrete headwall on LS toe.

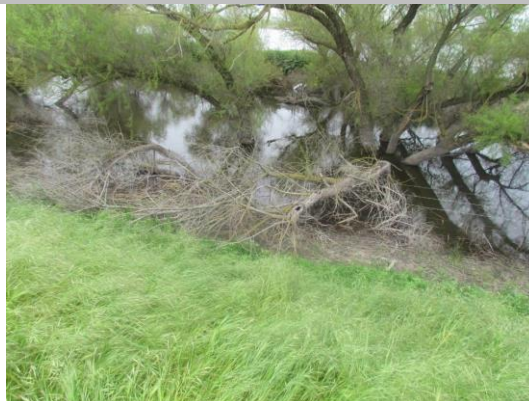
Photo 1 of 1 : SP_2017_NA0010_123_103_20170424_00283.jpg

LM Start	1.48	Rating **	M	Issue No.	103
LM End	1.48	Issue Type +	Ma	Location *	LS
Category	Earthen Levee			GPS Latitude/Longitude	
				Start	End
Item	Encroachments			37.265507 °	37.265507 °
				-120.804688 °	-120.804688 °
DWR ID	DWR_NA0010_05_s_2017_103				
Comment Code					
TR : Tree or limb					
Inspector Comment					
Fallen tree on landward toe.

Looking east at fallen tree at landward toe.
