**Flood Control Project Maintenance
Levee Inspections**

Maintenance Issue Types Only, Levee Inspection Report By Mile - Spring 2017

Lower San Joaquin Levee District

Waterway	Bank	Unit Miles	Inspection Start/End	Inspector
Unit No. 01 San Joaquin River	Right	22.52	04/17/2017 04/20/2017	Richard Willoughby

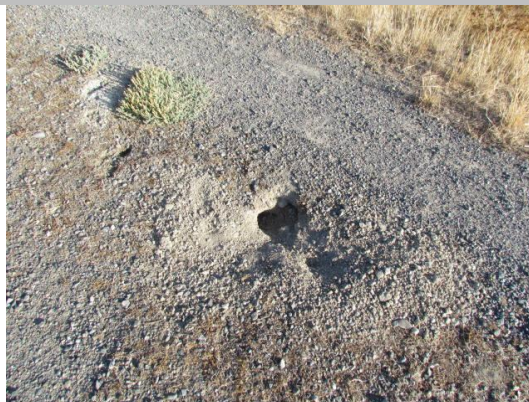
Photo 1 of 1 : SP_2017_NA0010_123_80_20170417_00010.jpg

LM Start	1.66	Rating **	M	Issue No.	80
LM End	1.75	Issue Type +	Ma	Location *	LS
Category	Earthen Levee			GPS Latitude/Longitude	
				Start	End
Item	Animal Control			37.263448 °	37.262225 °
				-120.802715 °	-120.802296 °
DWR ID	DWR_NA0010_05_f_2015_80				
Comment Code					
A3 : No rodents visible, but rodent burrows visible; need to backfill and compact or grout burrows.					
Inspector Comment					
Several rodent holes on levee crown within this section.

Looking at typical view of rodent holes within this section on landward slope.

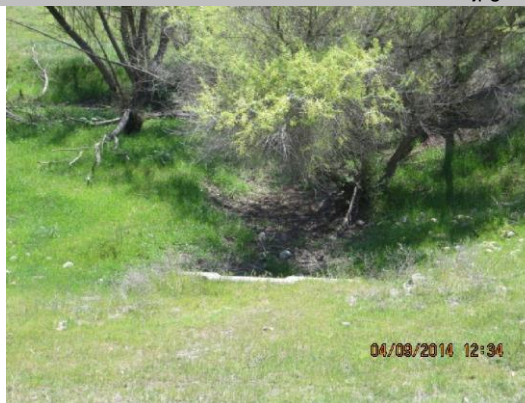
Photo 1 of 3 : UCIP_SP_2017_33709_60943.jpg

LM Start	2.84	Rating **	M	Issue No.	1317
LM End	2.84	Issue Type +	Ma	Location *	LS
Category	Supplemental			GPS Latitude/Longitude	
				Start	End
Item	DWR UCIP LMA Responsibility			37.256810 °	37.256810 °
				-120.785113 °	-120.785113 °
DWR ID					
Comment Code					
Inspector Comment					
FS_ID:33709 DS_ID:19809 EP_NO: N/A Repair Type: Non-Urgent Crossing Status: Found UCIP Comments: Log partially blocking inlet at LS toe. FIELD_STRUCT_DESC: 24-inch C.M. stormdrain pipe through the levee, 15.0 feet below the crown. Flap gate on the waterward end. Concrete "U" headwalls on both ends. (USACE-1967). This entry matches the Drainage or Irrigation Structure referenced in O&M manual (HLM 2.85). FS Date: 4/9/2014

Concrete headwall at outlet on WS toe.

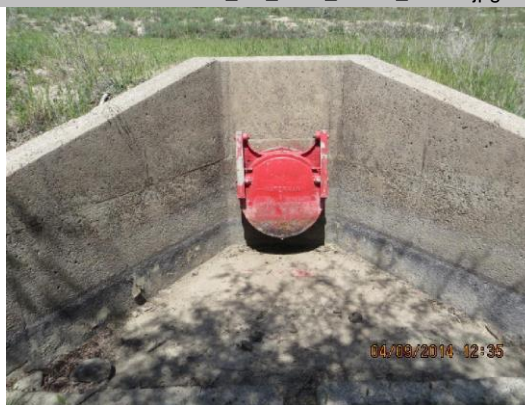
Photo 2 of 3 : UCIP_SP_2017_33709_60941.jpg

Headwall, pipe, and flapgate on WS toe.

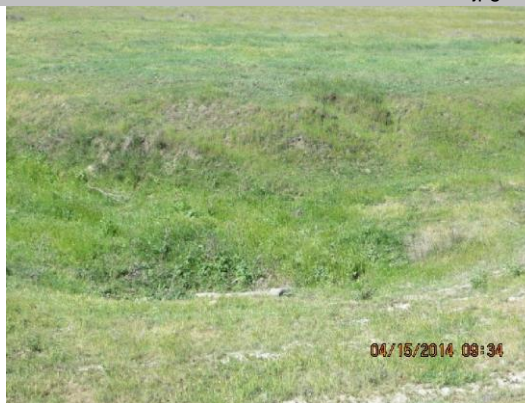
Photo 1 of 3 : UCIP_SP_2017_43055_60948.jpg

LM Start	3.34	Rating **	M	Issue No.	1318
LM End	3.34	Issue Type +	Ma	Location *	WS
Category	Supplemental			GPS Latitude/Longitude	
				Start	End
Item	DWR UCIP LMA Responsibility			37.255258 °	37.255258 °
				-120.776996 °	-120.776996 °
DWR ID					
Comment Code					
Inspector Comment					
FS_ID:43055					
DS_ID:19810					
EP_NO: N/A					
Repair Type: Non-Urgent					
Crossing Status: Found					
UCIP Comments: Pipe corroded through at flapgate on WS toe.					
FIELD_STRUCT_DESC: 24-inch C.M. stormdrain pipe through the					
levee, 14.7 feet below the crown. Flap gate on the waterward end.					
Concrete "U" headwalls on both ends. (USACE-1967). This entry					
matches the Drainage or Irrigation Structure referenced in O&M manual					
(HLM 3.33).					
FS Date: 4/15/2014

Concrete headwall at WS toe.

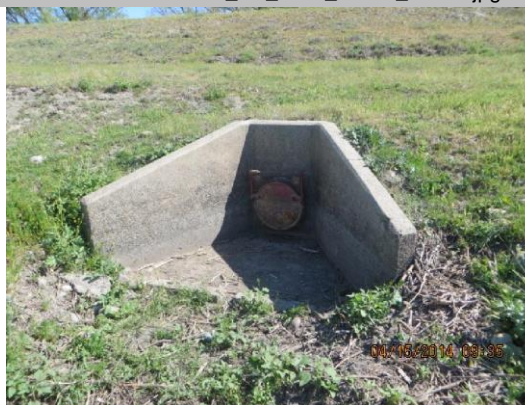
Photo 2 of 3 : UCIP_SP_2017_43055_60946.jpg

Flapgate and Concrete headwall at WS toe.

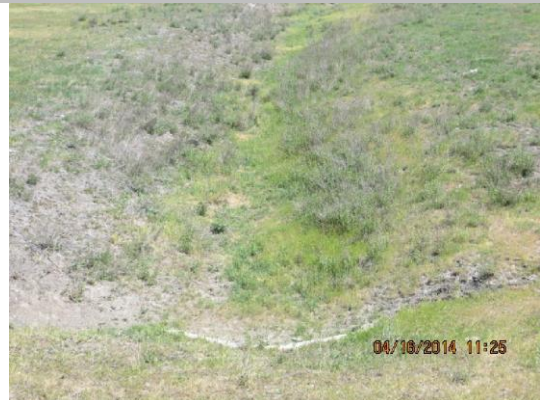
Photo 1 of 3 : UCIP_SP_2017_39586_61137.jpg

LM Start	3.68	Rating **	M	Issue No.	1319
LM End	3.68	Issue Type +	Ma	Location *	WS
Category	Supplemental			GPS Latitude/Longitude	
				Start	End
Item	DWR UCIP LMA Responsibility			37.252308 °	37.252308 °
				-120.768038 °	-120.768038 °
DWR ID					
Comment Code					
Inspector Comment					
FS_ID:39586 DS_ID:19811 EP_NO: N/A Repair Type: Non-Urgent Crossing Status: Found UCIP Comments: Sediment buildup in pipe visible from landward side--recommend contacting owner to clear pipe. FIELD_STRUCT_DESC: 24-inch C.M. stormdrain pipe through the levee, 15.0 feet below the crown. Flap gate on the waterward end. Concrete headwall on the landward end. Concrete "U" headwall on the waterward end. (USACE-1967). This entry matches the Drainage or Irrigation Structure referenced in O&M manual (HLM 3.67). FS Date: 4/16/2014

Pipe, headwall, and flapgate on WS toe.

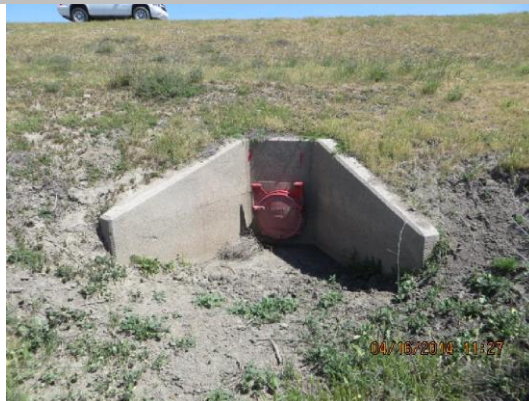
Photo 2 of 3 : UCIP_SP_2017_39586_61138.jpg

Pipe, headwall, and flapgate on WS toe.

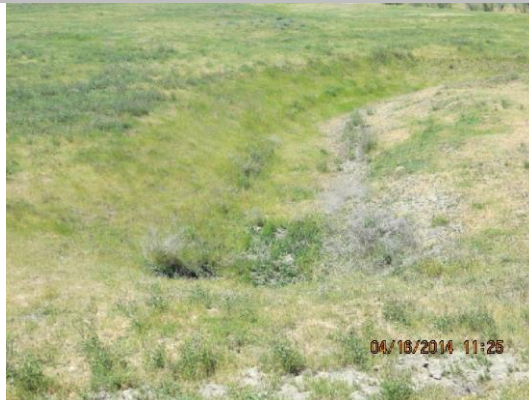
Photo 3 of 3 : UCIP_SP_2017_39586_61136.jpg

Pipe and headwall on LS toe.

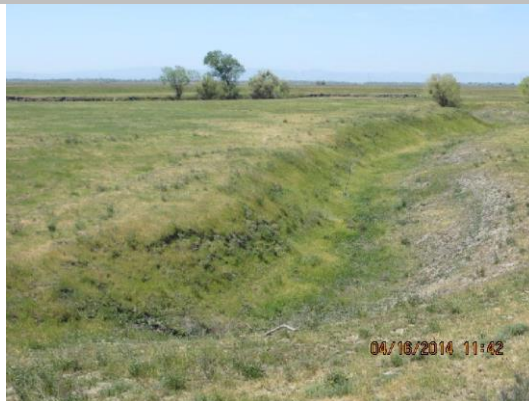
Photo 1 of 3 : UCIP_SP_2017_39880_61142.jpg

LM Start	4.02	Rating **	M	Issue No.	1320
LM End	4.02	Issue Type +	Ma	Location *	WS
Category	Supplemental			GPS Latitude/Longitude	
				Start	End
Item	DWR UCIP LMA Responsibility			37.248432 °	37.248432 °
				-120.764066 °	-120.764066 °
DWR ID					
Comment Code					
Inspector Comment					
FS_ID:39880 DS_ID:19769 EP_NO: N/A Repair Type: Non-Urgent Crossing Status: Found UCIP Comments: Sediment buildup in pipe visible from landward side--recommend contacting owner to clear pipe. FIELD_STRUCT_DESC: 24-inch C.M. stormdrain pipe through the levee, 16.0 feet below the crown. Flap gate on the waterward end. Concrete "U" headwalls on both ends. (USACE-1967). This entry matches the Drainage or Irrigation Structure referenced in O&M manual (HLM 4.02). FS Date: 4/16/2014

Pipe, headwall, and flapgate on WS toe.

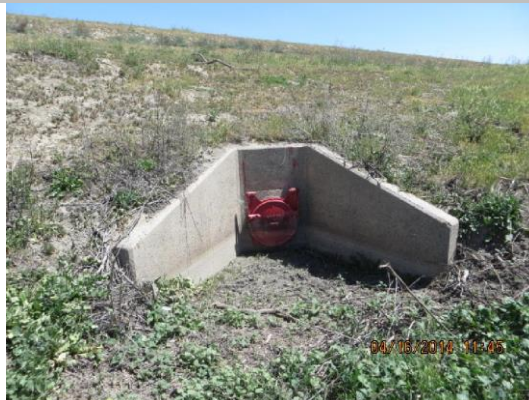
Photo 2 of 3 : UCIP_SP_2017_39880_61143.jpg

Pipe, headwall, and flapgate on WS toe.

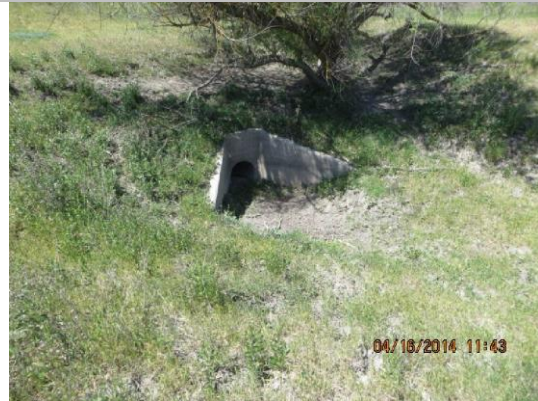
Photo 3 of 3 : UCIP_SP_2017_39880_61141.jpg

Pipe and headwall on LS toe.

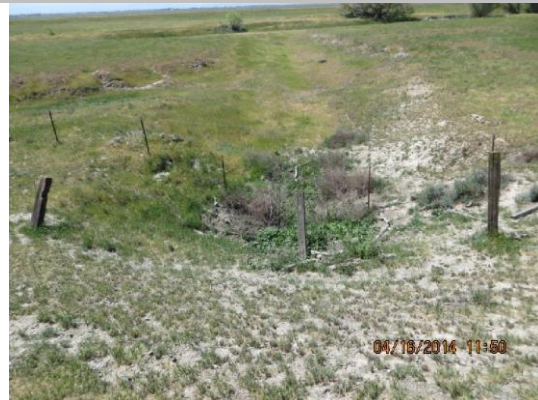
Photo 1 of 3 : UCIP_SP_2017_39588_61146.jpg

LM Start	4.27	Rating **	M	Issue No.	1321
LM End	4.27	Issue Type +	Ma	Location *	WS
Category	Supplemental			GPS Latitude/Longitude	
				Start	End
Item	DWR UCIP LMA Responsibility			37.246008 °	37.246008 °
				-120.760706 °	-120.760706 °
DWR ID					
Comment Code					
Inspector Comment					
FS_ID:39588 DS_ID:19770 EP_NO: N/A Repair Type: Non-Urgent Crossing Status: Found UCIP Comments: Sediment buildup in pipe visible from landward side--recommend contacting owner to clear pipe. FIELD_STRUCT_DESC: 24-inch C.M. stormdrain pipe through the levee, 11.6-feet below the crown. Flap gate on the waterward end. Concrete head wall on the landward end. Concrete "U" headwall on the waterward end. (USACE-1967). This entry matches the Drainage or Irrigation Structure referenced in O&M manual (HLM 4.27). FS Date: 4/16/2014

Pipe, headwall, and flapgate on WS toe.

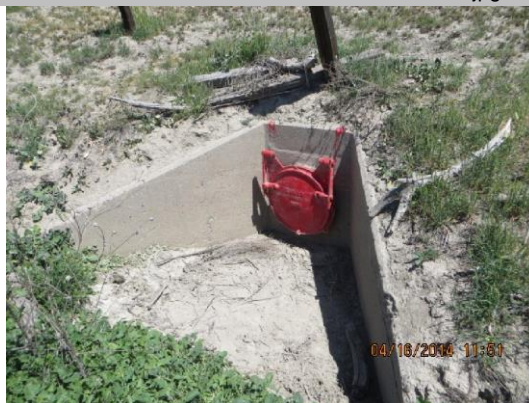
Photo 2 of 3 : UCIP_SP_2017_39588_61145.jpg

Pipe, headwall, and flapgate on WS toe.

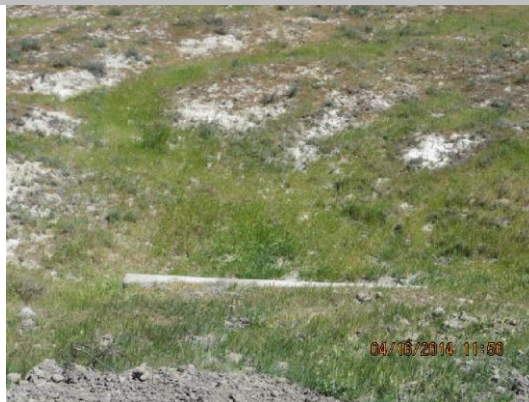
Photo 3 of 3 : UCIP_SP_2017_39588_61147.jpg

Concrete headwall and pipe on LS toe.

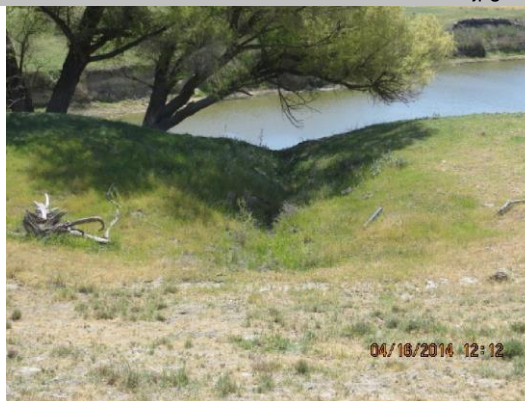
Photo 1 of 3 : UCIP_SP_2017_39591_62091.jpg

LM Start	5.15	Rating **	M	Issue No.	1324
LM End	5.15	Issue Type +	Ma	Location *	WS
Category	Supplemental			GPS Latitude/Longitude	
				Start	End
Item	DWR UCIP LMA Responsibility			37.240607 °	37.240607 °
				-120.746916 °	-120.746916 °
DWR ID					
Comment Code					
Inspector Comment					
FS_ID:39591 DS_ID:19773 EP_NO: N/A Repair Type: Non-Urgent Crossing Status: Found UCIP Comments: Heavy sediment buildup in pipe visible from landward side--recommend contacting owner to clear pipe. FIELD_STRUCT_DESC: 24-inch C.M. stormdrain pipe through the levee, 12.2-feet below the crown. Flap gate on the waterward end. Concrete headwall on the landward end. Concrete "U" headwall on the waterward end. (USACE-1967). This entry matches the Drainage or Irrigation Structure referenced in O&M manual (HLM 5.15). FS Date: 4/16/2014

Headwall, flapgate, and pipe on WS toe.

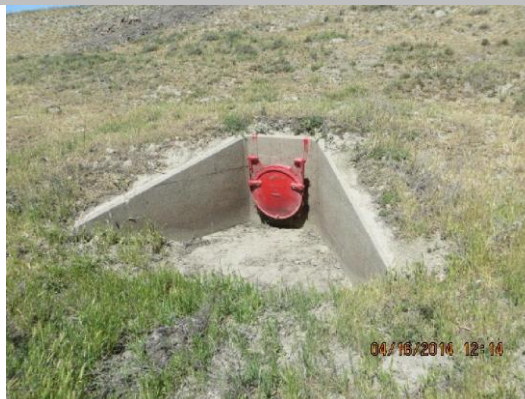
Photo 2 of 3 : UCIP_SP_2017_39591_62093.jpg

Headwall, flapgate, and pipe on WS toe.

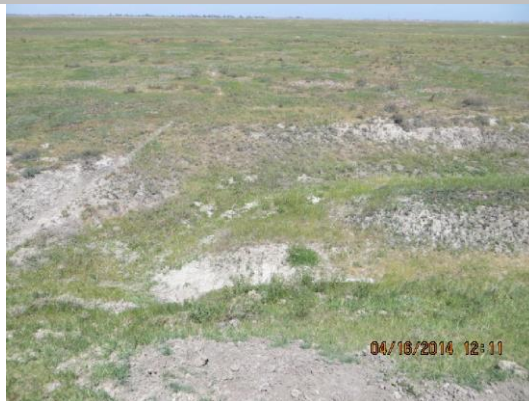
Photo 3 of 3 : UCIP_SP_2017_39591_62092.jpg

Headwall and pipe on LS toe.

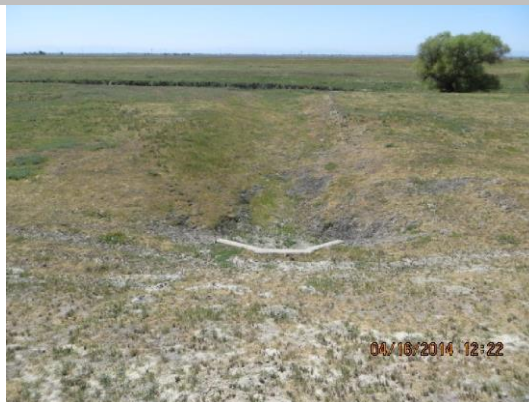
Photo 1 of 3 : UCIP_SP_2017_34151_62096.jpg

LM Start	5.58	Rating **	A/W	Issue No.	1325
LM End	5.58	Issue Type +	Ma	Location *	WS
Category	Supplemental			GPS Latitude/Longitude	
				Start	End
Item	DWR UCIP LMA Responsibility			37.238879 °	37.238879 °
				-120.739719 °	-120.739719 °
DWR ID					
Comment Code					
Inspector Comment					
FS_ID:34151					
DS_ID:19774					
EP_NO: N/A					
Repair Type: No Action Needed					
Crossing Status: Found					
UCIP Comments:					
FIELD_STRUCT_DESC: 24-inch C.M. stormdrain pipe through the					
levee, 9.5-feet below the crown. Flap gate on the waterward end.					
Concrete headwall on the landward end. Concrete "U" headwall on the					
waterward end. (USACE-1967). This entry matches the Drainage or					
Irrigation Structure referenced in O&M manual (HLM 5.58).					
FS Date: 4/16/2014

Headwall, flapgate, and pipe on WS toe.

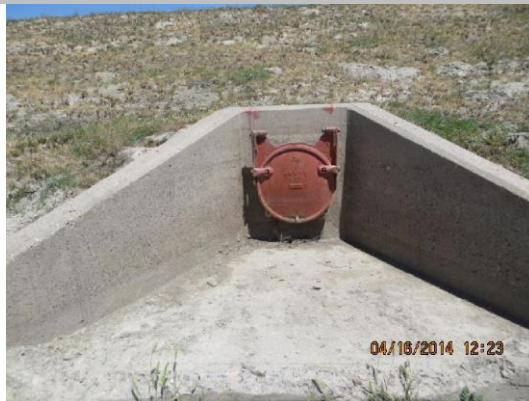
Photo 2 of 3 : UCIP_SP_2017_34151_62095.jpg

Headwall, flapgate, and pipe on WS toe.

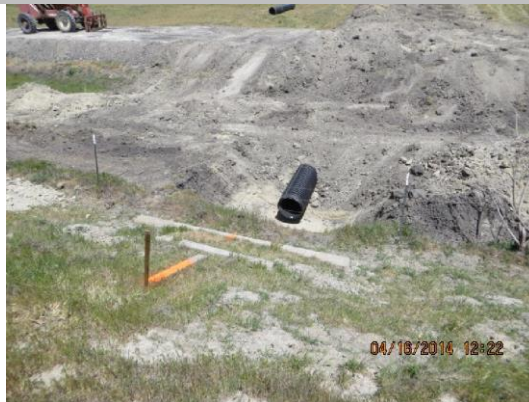
Photo 3 of 3 : UCIP_SP_2017_34151_62097.jpg

LM Start	5.58	Rating **	A/W	Issue No.	1325 (cont)
LM End	5.58	Issue Type +	Ma	Location *	WS
Category	Supplemental			GPS Latitude/Longitude	
				Start	End
Item	DWR UCIP LMA Responsibility			37.238879 °	37.238879 °
				-120.739719 °	-120.739719 °
DWR ID					
Comment Code					
Inspector Comment					
FS_ID:34151					
DS_ID:19774					
EP_NO: N/A					
Repair Type: No Action Needed					
Crossing Status: Found					
UCIP Comments:					
FIELD_STRUCT_DESC: 24-inch C.M. stormdrain pipe through the					
levee, 9.5-feet below the crown. Flap gate on the waterward end.					
Concrete headwall on the landward end. Concrete "U" headwall on the					
waterward end. (USACE-1967). This entry matches the Drainage or					
Irrigation Structure referenced in O&M manual (HLM 5.58).					
FS Date: 4/16/2014

Headwall and pipe on LS toe with HDPE drain pipe being installed off LS toe.

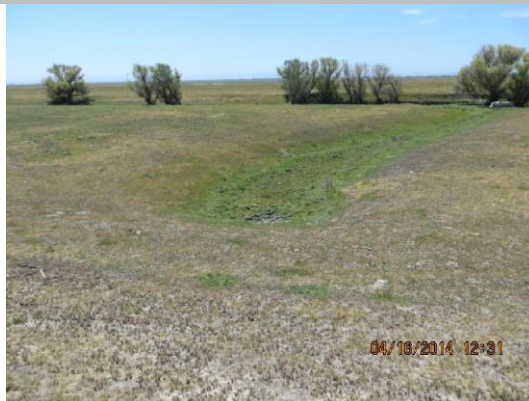
Photo 1 of 3 : UCIP_SP_2017_34163_62102.jpg

LM Start	6.35	Rating **	A/W	Issue No.	1326
LM End	6.35	Issue Type +	Ma	Location *	WS
Category	Supplemental			GPS Latitude/Longitude	
				Start	End
Item	DWR UCIP LMA Responsibility			37.232589 °	37.232589 °
				-120.728822 °	-120.728822 °
DWR ID					
Comment Code					
Inspector Comment					
FS_ID:34163 DS_ID:19775 EP_NO: N/A Repair Type: No Action Needed Crossing Status: Found UCIP Comments: FIELD_STRUCT_DESC: 24-inch C.M. stormdrain pipe through the levee, 13.0-feet below the crown. Flap gate on the waterward end. Concrete headwall on the landward end. Concrete "U" headwall on the waterward end. (USACE-1967). This entry matches the Drainage or Irrigation Structure referenced in O&M manual (HLM 6.35). FS Date: 4/16/2014

Headwall, flapgate, and pipe on WS toe.

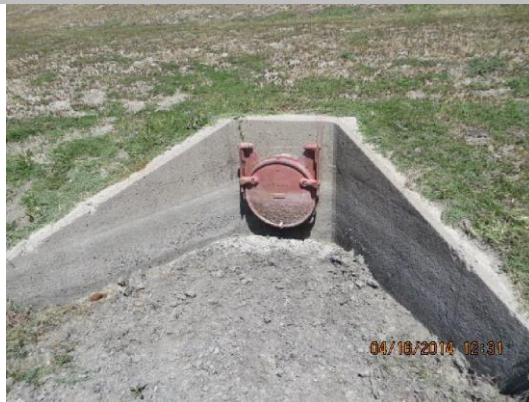
Photo 2 of 3 : UCIP_SP_2017_34163_62101.jpg

Headwall, flapgate, and pipe on WS toe.

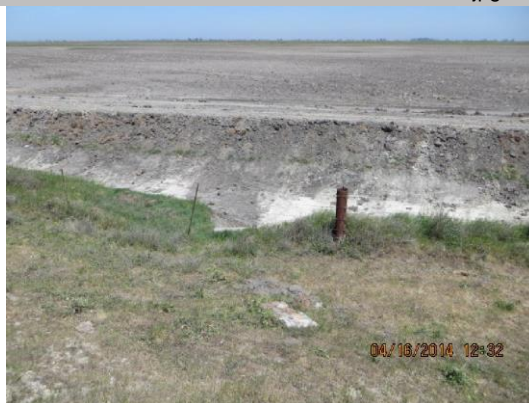
Photo 3 of 3 : UCIP_SP_2017_34163_62100.jpg

LM Start	6.35	Rating **	A/W	Issue No.	1326 (cont)	
LM End	6.35	Issue Type +	Ma	Location *	WS	
Category	Supplemental			GPS Latitude/Longitude		
				Start	End	
Item	DWR UCIP LMA Responsibility			37.232589 °	37.232589 °	
				-120.728822 °	-120.728822 °	
DWR ID						
Comment Code						
Inspector Comment						
FS_ID:34163 DS_ID:19775 EP_NO: N/A Repair Type: No Action Needed Crossing Status: Found UCIP Comments: FIELD_STRUCT_DESC: 24-inch C.M. stormdrain pipe through the levee, 13.0-feet below the crown. Flap gate on the waterward end. Concrete headwall on the landward end. Concrete "U" headwall on the waterward end. (USACE-1967). This entry matches the Drainage or Irrigation Structure referenced in O&M manual (HLM 6.35). FS Date: 4/16/2014

Headwall and pipe on LS toe.

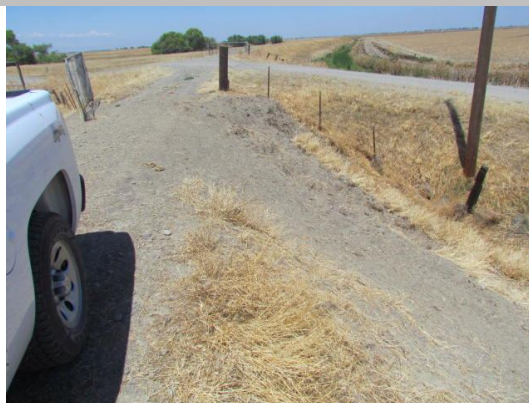
Photo 1 of 2 : SP_2017_NA0010_123_1309_20170417_00013.jpg

LM Start	6.59	Rating **	M	Issue No.	1309
LM End	6.59	Issue Type +	Ma	Location *	LS
Category	Earthen Levee			GPS Latitude/Longitude	
				Start	End
Item	Slope Stability			37.229682 °	37.229682 °
				-120.726305 °	-120.726305 °
DWR ID	DWR_NA0010_05_s_2015_1309				
Comment Code					
S2 : Repair the levee slope damaged by foot traffic and prevent access where possible.					
Inspector Comment					
Landward slope damage caused by animal foot traffic.

Looking north at damaged landward slope.

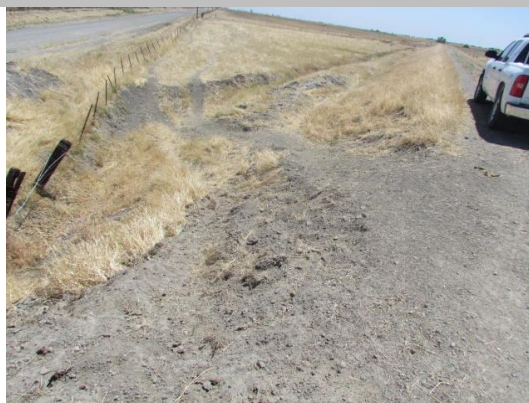
Photo 2 of 2 : SP_2017_NA0010_123_1309_20170417_00014.jpg

Looking east at damaged landward slope.

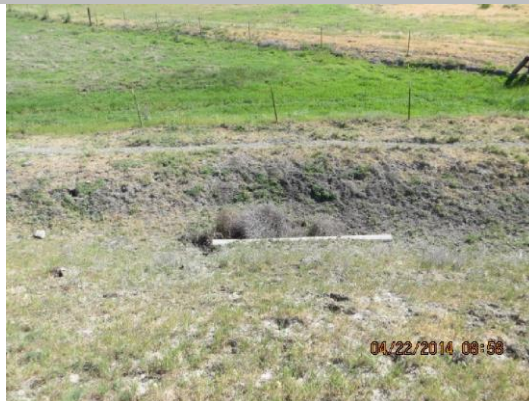
Photo 3 of 3 : UCIP_SP_2017_39592_62112.jpg

LM Start	7.36	Rating **	M	Issue No.	1327 (cont)
LM End	7.36	Issue Type +	Ma	Location *	LS
Category	Supplemental			GPS Latitude/Longitude	
				Start	End
Item	DWR UCIP LMA Responsibility			37.224560 °	37.224560 °
				-120.714057 °	-120.714057 °
DWR ID					
Comment Code					
Inspector Comment					
FS_ID:39592 DS_ID:19761 EP_NO: N/A Repair Type: Non-Urgent Crossing Status: Found UCIP Comments: Sediment buildup in pipe visible from landward side--recommend contacting owner to clear pipe. FIELD_STRUCT_DESC: 24-inch C.M. stormdrain pipe through the levee, 12.0-feet below the crown. Flap gate on the waterward end. Concrete headwall on the landward end. Concrete "U" headwall on the waterward end. (USACE-1967). This entry matches the Drainage or Irrigation Structure referenced in O&M manual (HLM 7.36). FS Date: 4/22/2014

Headwall and pipe on LS toe.

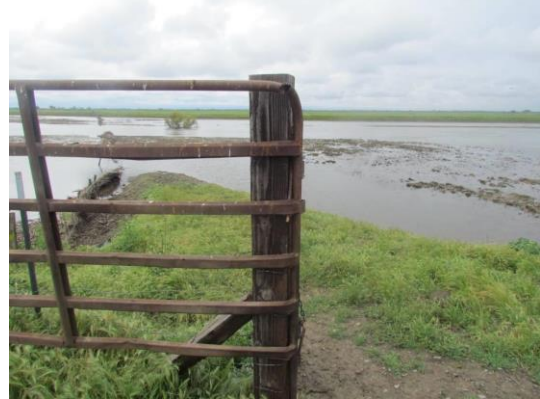
Photo 1 of 1 : SP_2017_NA0010_123_104_20170424_00284.jpg

LM Start	8.09	Rating **	M	Issue No.	104
LM End	8.09	Issue Type +	Ma	Location *	CR
Category	Earthen Levee			GPS Latitude/Longitude	
				Start	End
Item	Repair Gates			37.213580 °	37.213580 °
				-120.706550 °	-120.706550 °
DWR ID	DWR_NA0010_05_s_2017_104				
Comment Code					
Inspector Comment					
Replace or repair gate not opening correctly bend fence post.

Looking bend gate near hinge point.

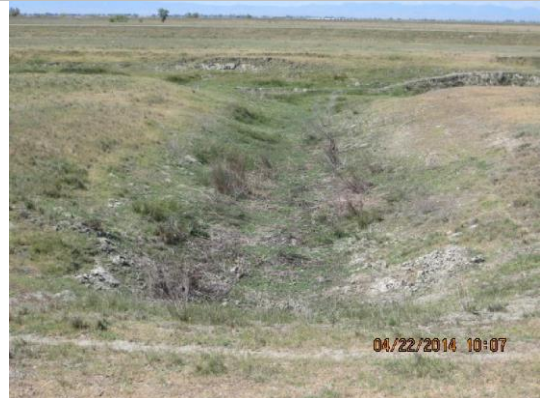
Photo 1 of 3 : UCIP_SP_2017_34265_62182.jpg

LM Start	8.46	Rating **	M	Issue No.	1329
LM End	8.46	Issue Type +	Ma	Location *	CR
Category	Supplemental			GPS Latitude/Longitude	
				Start	End
Item	DWR UCIP LMA Responsibility			37.209606 °	37.209606 °
				-120.702069 °	-120.702069 °
DWR ID					
Comment Code					
Inspector Comment					
FS_ID:34265					
DS_ID:19763					
EP_NO: N/A					
Repair Type: Non-Urgent					
Crossing Status: Found					
UCIP Comments: Pipe filled with silt on LS toe and should be cleared.					
FIELD_STRUCT_DESC: 24-inch CM stormdrain pipe through the levee,					
16.0-feet below the crown. Flap gate on the waterward end. Concrete					
headwall on the landward end. Concrete "U" headwalls on the					
waterward end. (USACE-1967). This entry matches the Drainage or					
Irrigation Structure referenced in O&M manual (HLM 8.44).					
FS Date: 4/22/2014

Headwall, flapgate, and pipe on WS toe

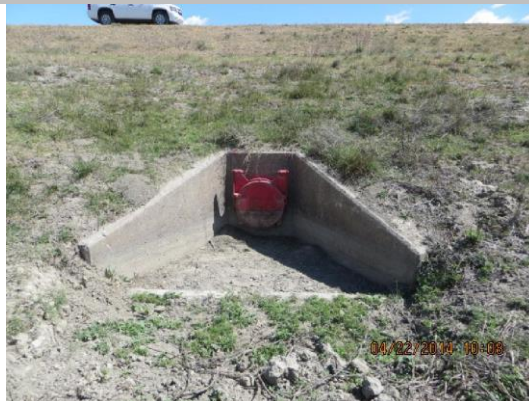
Photo 2 of 3 : UCIP_SP_2017_34265_62183.jpg

LM Start	8.46	Rating **	M	Issue No.	1329 (cont)	
LM End	8.46	Issue Type +	Ma	Location *	CR	
Category	Supplemental			GPS Latitude/Longitude		
				Start	End	
Item	DWR UCIP LMA Responsibility			37.209606 °	37.209606 °	
				-120.702069 °	-120.702069 °	
DWR ID						
Comment Code						
Inspector Comment						
FS_ID:34265						
DS_ID:19763						
EP_NO: N/A						
Repair Type: Non-Urgent						
Crossing Status: Found						
UCIP Comments: Pipe filled with silt on LS toe and should be cleared.						
FIELD_STRUCT_DESC: 24-inch CM stormdrain pipe through the levee,						
16.0-feet below the crown. Flap gate on the waterward end. Concrete						
headwall on the landward end. Concrete "U" headwalls on the						
waterward end. (USACE-1967). This entry matches the Drainage or						
Irrigation Structure referenced in O&M manual (HLM 8.44).						
FS Date: 4/22/2014

Headwall, flapgate, and pipe on WS toe

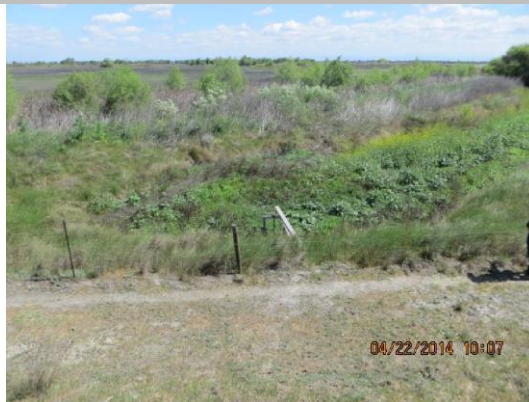
Photo 3 of 3 : UCIP_SP_2017_34265_62181.jpg

Headwall, slidegate, and pipe on LS toe.

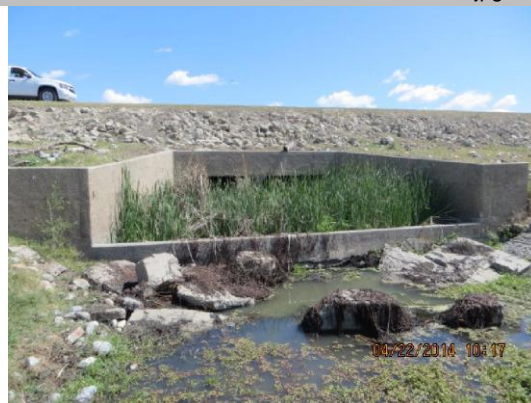
Photo 2 of 3 : UCIP_SP_2017_34268_62191.jpg

LM Start	8.85	Rating **	A/W	Issue No.	1331 (cont)
LM End	8.85	Issue Type +	Ma	Location *	CR
Category	Supplemental			GPS Latitude/Longitude	
				Start	End
Item	DWR UCIP LMA Responsibility			37.205784 °	37.205784 °
				-120.696843 °	-120.696843 °
DWR ID					
Comment Code					
Inspector Comment					
FS_ID:34268 DS_ID:19735 EP_NO: N/A Repair Type: No Action Needed Crossing Status: Found UCIP Comments: FIELD_STRUCT_DESC: 2 of 2: 48x102-inch R.C.B.C. stormdrain through the levee, 13.8-feet below the crown. Concrete "U" headwall on the waterward end. Concrete headwall on the landward end with slide gates mounted on the headwall. Waterward slope and outlet drain cobble revetted. (USACE-1967). This entry matches the Drainage or Irrigation Structure referenced in O&M manual (HLM 8.83). [Deadman Creek Drainage Ditch Structure] FS Date: 4/22/2014

Concrete headwall on WS toe.

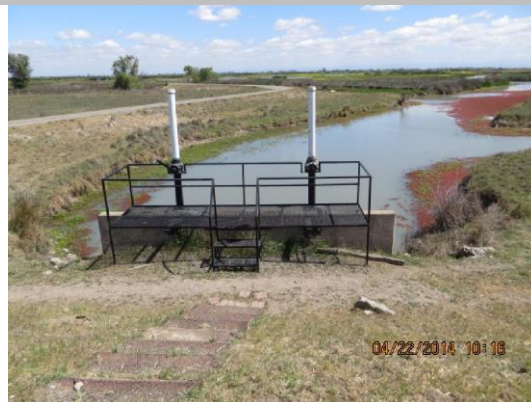
Photo 3 of 3 : UCIP_SP_2017_34268_62189.jpg

Slide gate mounted on concrete headwall at LS toe.

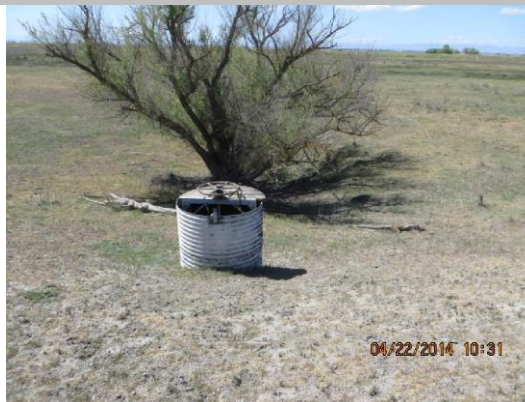
Photo 1 of 3 : UCIP_SP_2017_34272_62196.jpg

LM Start	9.28	Rating **	A/W	Issue No.	1332
LM End	9.28	Issue Type +	Ma	Location *	WS
Category	Supplemental			GPS Latitude/Longitude	
				Start	End
Item	DWR UCIP LMA Responsibility			37.202742 °	37.202742 °
				-120.690064 °	-120.690064 °
DWR ID					
Comment Code					
Inspector Comment					
FS_ID:34272					
DS_ID:19766					
EP_NO: N/A					
Repair Type: No Action Needed					
Crossing Status: Found					
UCIP Comments:					
FIELD_STRUCT_DESC: 36-inch CM stormdrain pipe through the levee, 14.8-feet below the crown. Slide gate in a 48-inch CM pipe riser in the waterward slope. Concrete headwall on both ends. (USACE-1967). This entry matches the Drainage or Irrigation Structure referenced in O&M manual (HLM 9.26).					
FS Date: 4/22/2014

Slide gate in 48-inch CMP riser on WS slope.

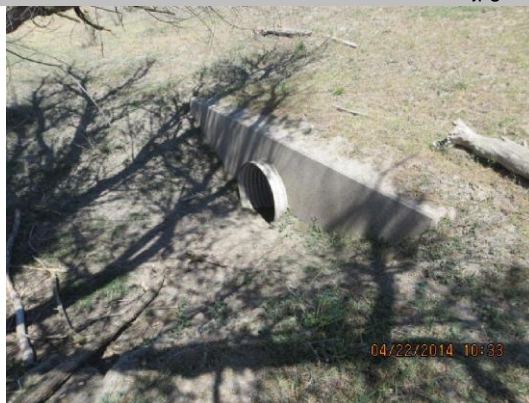
Photo 2 of 3 : UCIP_SP_2017_34272_62198.jpg

LM Start	9.28	Rating **	A/W	Issue No.	1332 (cont)	
LM End	9.28	Issue Type +	Ma	Location *	WS	
Category	Supplemental			GPS Latitude/Longitude		
				Start	End	
Item	DWR UCIP LMA Responsibility			37.202742 °	37.202742 °	
				-120.690064 °	-120.690064 °	
DWR ID						
Comment Code						
Inspector Comment						
FS_ID:34272						
DS_ID:19766						
EP_NO: N/A						
Repair Type: No Action Needed						
Crossing Status: Found						
UCIP Comments:						
FIELD_STRUCT_DESC: 36-inch CM stormdrain pipe through the levee, 14.8-feet below the crown. Slide gate in a 48-inch CM pipe riser in the waterward slope. Concrete headwall on both ends. (USACE-1967). This entry matches the Drainage or Irrigation Structure referenced in O&M manual (HLM 9.26).						
FS Date: 4/22/2014

Headwall and pipe at WS toe.

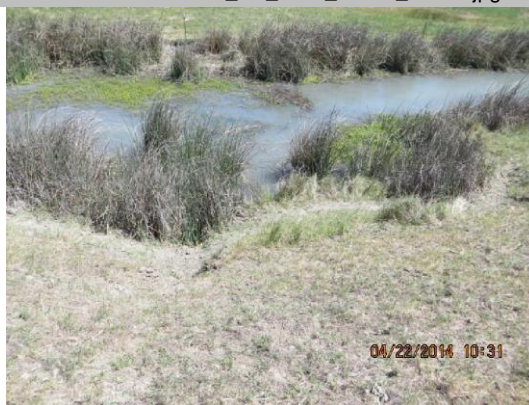
Photo 3 of 3 : UCIP_SP_2017_34272_62197.jpg

Headwall and pipe at LS toe.

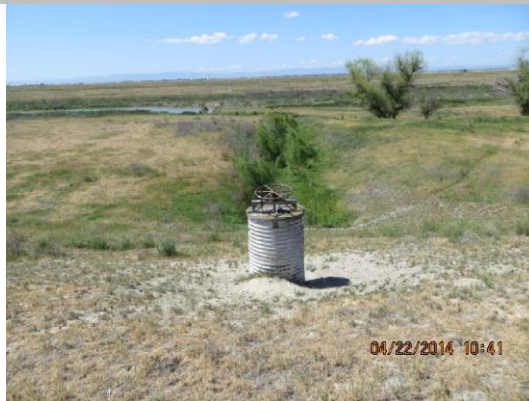
Photo 1 of 3 : UCIP_SP_2017_34273_62201.jpg

LM Start	10.06	Rating **	M	Issue No.	1333
LM End	10.06	Issue Type +	Ma	Location *	WS
Category	Supplemental			GPS Latitude/Longitude	
				Start	End
Item	DWR UCIP LMA Responsibility			37.194736 °	37.194736 °
				-120.680116 °	-120.680116 °
DWR ID					
Comment Code					
Inspector Comment					
FS_ID:34273 DS_ID:19767 EP_NO: N/A Repair Type: Non-Urgent Crossing Status: Found UCIP Comments: Slidegate actuator appears bent and may not work properly (WS slope). FIELD_STRUCT_DESC: 24-inch CM stormdrain pipe through the levee, 15.0-feet below the crown. Slide gate in 36-inch CM pipe riser on the waterward slope. Concrete headwall on both ends. (USACE-1967). This entry matches the Drainage or Irrigation Structure referenced in O&M manual (HLM 10.05). FS Date: 4/22/2014

Slidegate in CMP riser on WS slope.

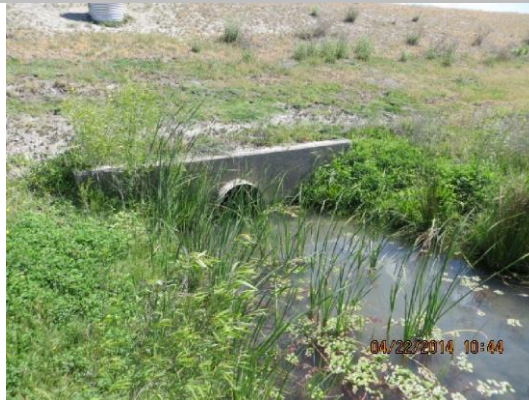
Photo 2 of 3 : UCIP_SP_2017_34273_62202.jpg

Concrete headwall and pipe on WS toe.

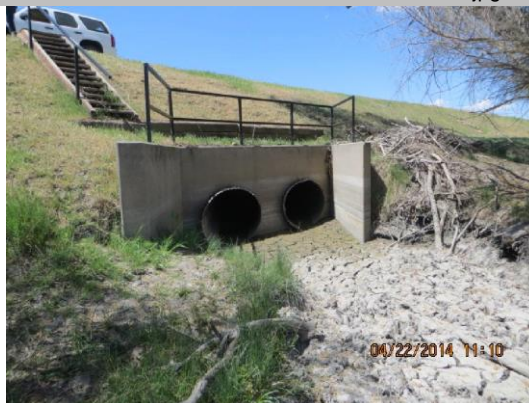
Photo 2 of 3 : UCIP_SP_2017_34281_62217.jpg

LM Start	11.49	Rating **	A/W	Issue No.	1334 (cont)
LM End	11.49	Issue Type +	Ma	Location *	WS
Category	Supplemental			GPS Latitude/Longitude	
				Start	End
Item	DWR UCIP LMA Responsibility			37.186471 °	37.186471 °
				-120.657915 °	-120.657915 °
DWR ID					
Comment Code					
Inspector Comment					
FS_ID:34281 DS_ID:19768 EP_NO: N/A Repair Type: No Action Needed Crossing Status: Found UCIP Comments: FIELD_STRUCT_DESC: 1 of 2: 48-inch CM stormdrain pipe through the levee, 16.0-feet below the crown. Slide gates in 60-inch CM pipe risers in the waterward slope. Concrete "U" headwalls on both ends. (USACE-1967). This entry matches the Drainage or Irrigation Structure referenced in O&M manual (HLM 11.48). Stairs on LS slope. [Deadman Drain Structure] FS Date: 4/22/2014

Stairs, concrete headwall, and pipe visible on LS slope.

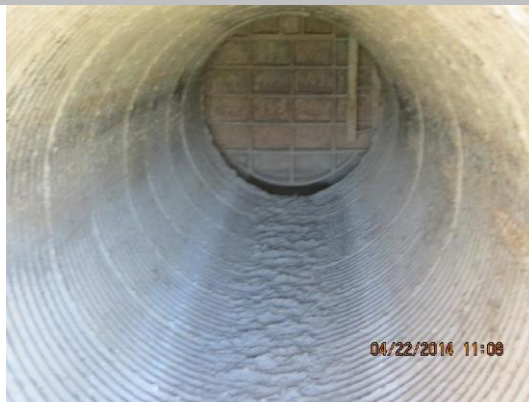
Photo 3 of 3 : UCIP_SP_2017_34281_62218.jpg

Inside pipe at LS toe.

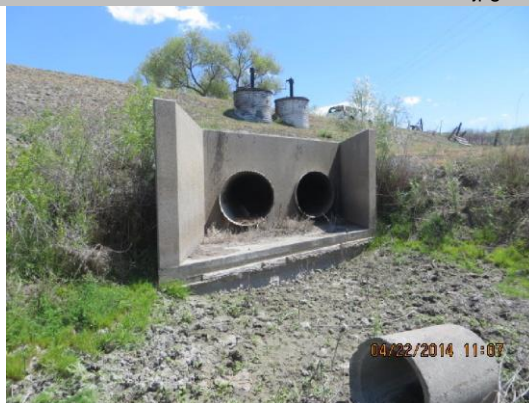
Photo 1 of 3 : UCIP_SP_2017_34280_62216.jpg

LM Start	11.50	Rating **	A/W	Issue No.	1335
LM End	11.50	Issue Type +	Ma	Location *	WS
Category	Supplemental			GPS Latitude/Longitude	
				Start	End
Item	DWR UCIP LMA Responsibility			37.186458 °	37.186458 °
				-120.657903 °	-120.657903 °
DWR ID					
Comment Code					
Inspector Comment					
FS_ID:34280 DS_ID:19734 EP_NO: N/A Repair Type: No Action Needed Crossing Status: Found UCIP Comments: FIELD_STRUCT_DESC: 2 of 2: 48-inch CM stormdrain pipe through the levee, 16.0 feet below the crown. Slide gate in 60-inch CM pipe riser on the waterward slope. Concrete "U" headwalls on both ends. (USACE-1967). This entry matches the Drainage or Irrigation Structure referenced in O&M manual (HLM 11.48). [Deadman Drain Structure] FS Date: 4/22/2014

Concrete headwall, pipe, and slidegate in CMP riser on WS of levee.

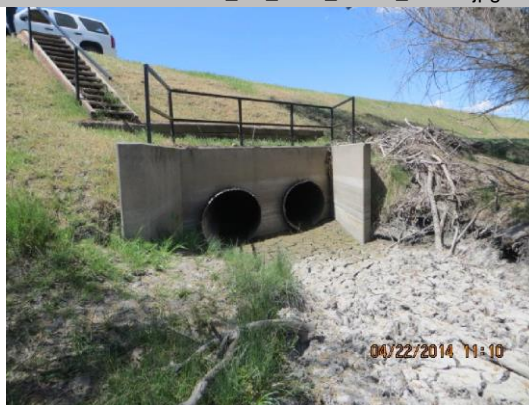
Photo 2 of 3 : UCIP_SP_2017_34280_62214.jpg

Stairs, concrete headwall and pipe on LS toe.

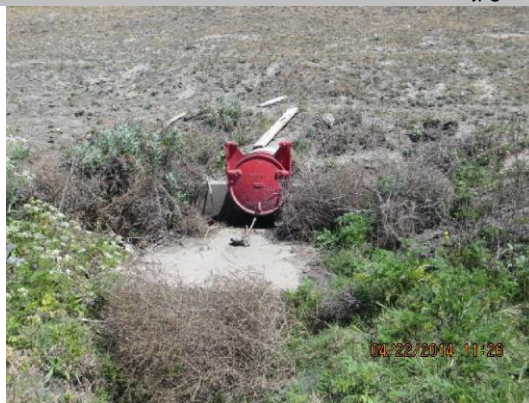
Photo 2 of 3 : UCIP_SP_2017_34283_62223.jpg

LM Start	11.65	Rating **	A/W	Issue No.	1336 (cont)
LM End	11.65	Issue Type +	Ma	Location *	WS
Category	Supplemental			GPS Latitude/Longitude	
				Start	End
Item	DWR UCIP LMA Responsibility			37.184830 °	37.184830 °
				-120.656016 °	-120.656016 °
DWR ID					
Comment Code					
Inspector Comment					
FS_ID:34283					
DS_ID:19704					
EP_NO: N/A					
Repair Type: No Action Needed					
Crossing Status: Found					
UCIP Comments:					
FIELD_STRUCT_DESC: 24-inch CM stormdrain pipe through the levee, 11.8-feet below the crown. Flap gate on the waterward end. Concrete headwall on the landward end. Concrete saddle and apron on the waterward end. (USACE-1967). This entry matches the Drainage or Irrigation Structure referenced in O&M manual (HLM 11.63).					
FS Date: 4/22/2014

Headwall, flapgate, and pipe at WS toe.

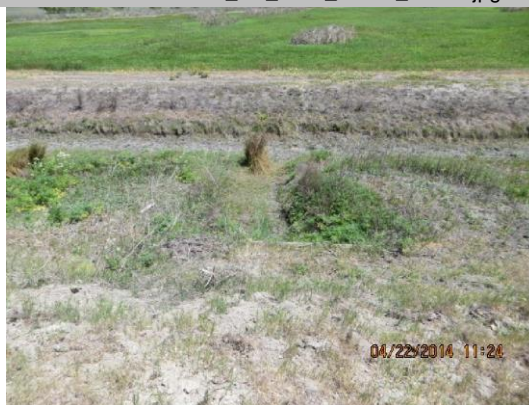
Photo 3 of 3 : UCIP_SP_2017_34283_62222.jpg

Concrete headwall and pipe at LS toe.

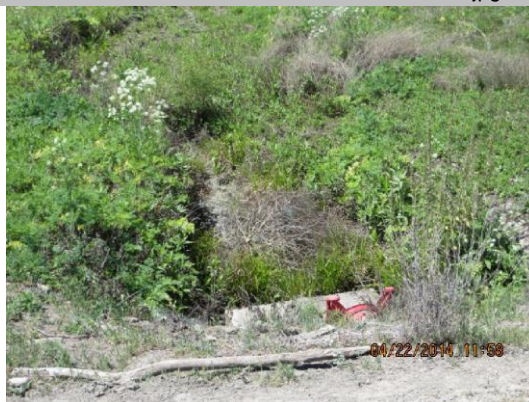
Photo 1 of 3 : UCIP_SP_2017_34284_62225.jpg

LM Start	12.01	Rating **	A/W	Issue No.	1337
LM End	12.01	Issue Type +	Ma	Location *	WS
Category	Supplemental			GPS Latitude/Longitude	
				Start	End
Item	DWR UCIP LMA Responsibility			37.180291 °	37.180291 °
				-120.653931 °	-120.653931 °
DWR ID					
Comment Code					
Inspector Comment					
FS_ID:34284 DS_ID:19705 EP_NO: N/A Repair Type: No Action Needed Crossing Status: Found UCIP Comments: FIELD_STRUCT_DESC: 24-inch CM stormdrain pipe through the levee, 12.5 feet below the crown. Flap gate on the waterward end. Concrete headwall on the landward end. Concrete headwall on the landward end. Concrete saddle and apron on the waterward end. Flashboard attachment on the landward end. (USACE-1967). This entry matches the Drainage or Irrigation Structure referenced in O&M manual (HLM 11.99). FS Date: 4/22/2014

Headwall, flapgate, and pipe on WS toe.

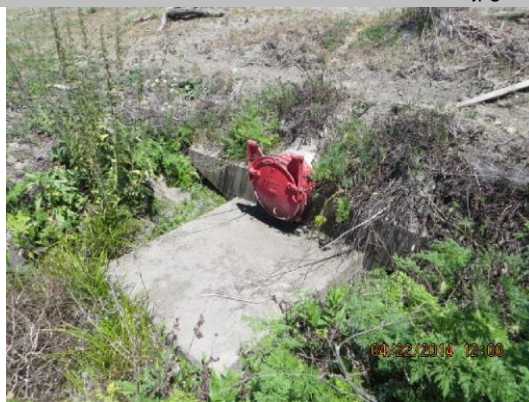
Photo 2 of 3 : UCIP_SP_2017_34284_62227.jpg

LM Start	12.01	Rating **	A/W	Issue No.	1337 (cont)
LM End	12.01	Issue Type +	Ma	Location *	WS

Headwall, flapgate, and pipe on WS toe.

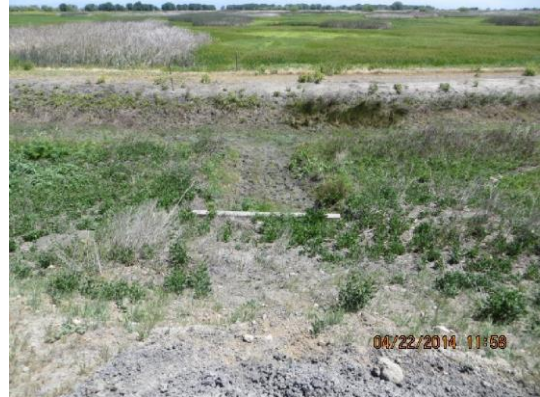
Photo 3 of 3 : UCIP_SP_2017_34284_62226.jpg

LM Start	12.01	Rating **	A/W	Issue No.	1337 (cont)
LM End	12.01	Issue Type +	Ma	Location *	WS
Category	Supplemental			GPS Latitude/Longitude	
				Start	End
Item	DWR UCIP LMA Responsibility			37.180291 °	37.180291 °
				-120.653931 °	-120.653931 °
DWR ID					
Comment Code					
Inspector Comment					
FS_ID:34284 DS_ID:19705 EP_NO: N/A Repair Type: No Action Needed Crossing Status: Found UCIP Comments: FIELD_STRUCT_DESC: 24-inch CM stormdrain pipe through the levee, 12.5 feet below the crown. Flap gate on the waterward end. Concrete headwall on the landward end. Concrete headwall on the landward end. Concrete saddle and apron on the waterward end. Flashboard attachment on the landward end. (USACE-1967). This entry matches the Drainage or Irrigation Structure referenced in O&M manual (HLM 11.99). FS Date: 4/22/2014

Headwall and pipe on LS toe.

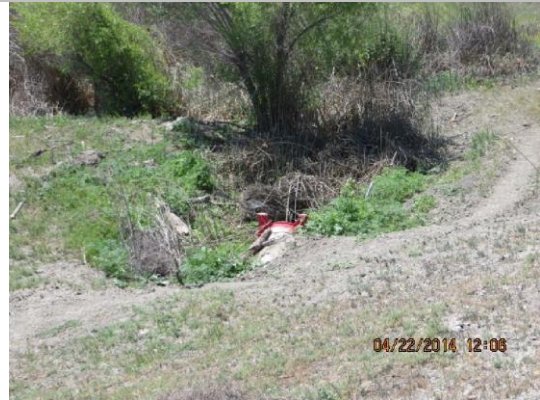
Photo 1 of 3 : UCIP_SP_2017_34285_62230.jpg

LM Start	12.40	Rating **	A/W	Issue No.	1338
LM End	12.40	Issue Type +	Ma	Location *	WS
Category	Supplemental			GPS Latitude/Longitude	
				Start	End
Item	DWR UCIP LMA Responsibility			37.175958 °	37.175958 °
				-120.649798 °	-120.649798 °
DWR ID					
Comment Code					
Inspector Comment					
FS_ID:34285					
DS_ID:19706					
EP_NO: N/A					
Repair Type: No Action Needed					
Crossing Status: Found					
UCIP Comments:					
FIELD_STRUCT_DESC: 24-inch CM stormdrain pipe through the levee, 10.2-feet below the crown. Flap gate on the waterward end. Concrete headwall on the landward end. Concrete saddle and apron on the waterward end. Flashboard attachment on the landward end. (USACE-1967). This entry matches the Drainage or Irrigation Structure referenced in O&M manual (HLM 12.38). Pipe crosses levee at 45 degrees to crown alignment.					
FS Date: 4/22/2014

Headwall, flapgate, and pipe on WS toe.

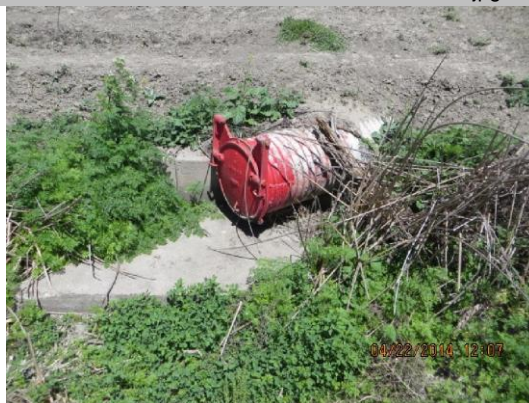
Photo 2 of 3 : UCIP_SP_2017_34285_62229.jpg

LM Start	12.40	Rating **	A/W	Issue No.	1338 (cont)
LM End	12.40	Issue Type +	Ma	Location *	WS
Category	Supplemental			GPS Latitude/Longitude	
				Start	End
Item	DWR UCIP LMA Responsibility			37.175958 °	37.175958 °
				-120.649798 °	-120.649798 °
DWR ID					
Comment Code					
Inspector Comment					
FS_ID:34285 DS_ID:19706 EP_NO: N/A Repair Type: No Action Needed Crossing Status: Found UCIP Comments: FIELD_STRUCT_DESC: 24-inch CM stormdrain pipe through the levee, 10.2-feet below the crown. Flap gate on the waterward end. Concrete headwall on the landward end. Concrete saddle and apron on the waterward end. Flashboard attachment on the landward end. (USACE-1967). This entry matches the Drainage or Irrigation Structure referenced in O&M manual (HLM 12.38). Pipe crosses levee at 45 degrees to crown alignment. FS Date: 4/22/2014

Headwall, flapgate, and pipe on WS toe.

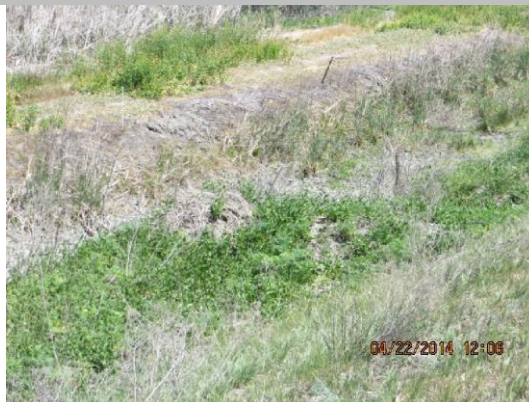
Photo 3 of 3 : UCIP_SP_2017_34285_62231.jpg

LM Start	12.40	Rating **	A/W	Issue No.	1338 (cont)
LM End	12.40	Issue Type +	Ma	Location *	WS

Headwall and pipe on LS toe.

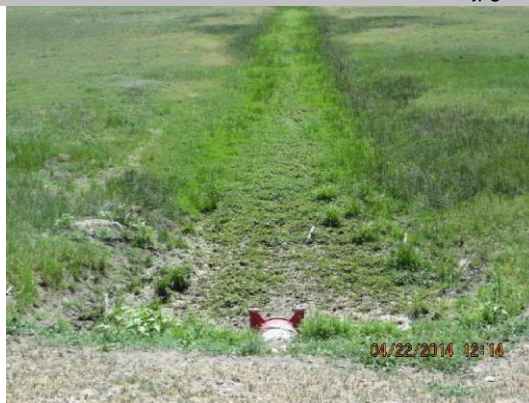
Photo 1 of 3 : UCIP_SP_2017_39593_62240.jpg

FS_ID:39593
DS_ID:19707
EP_NO: N/A
Repair Type: Non-Urgent
Crossing Status: Found
UCIP Comments: Sediment buildup in pipe visible from landward side--recommend contacting owner to clear pipe.
FIELD_STRUCT_DESC: 24-inch CM stormdrain pipe through the levee, 10.2-feet below the crown. Flap gate on the waterward end. Concrete headwalls on the landward end with flashboards. Concrete saddle and apron on the waterward end with a flapgate. Metal screen at LS toe inlet (USACE-1967). This entry matches the Drainage or Irrigation Structure referenced in O&M manual (HLM 12.87).
FS Date: 4/22/2014

Headwall, flapgate, and pipe on WS toe.

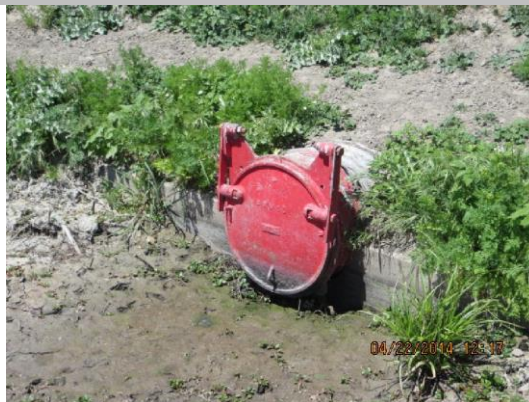
Photo 2 of 3 : UCIP_SP_2017_39593_62241.jpg

Headwall, flapgate, and pipe on WS toe.

Comment Code					
Inspector Comment					
FS_ID:39593					
DS_ID:19707					
EP_NO: N/A					
Repair Type: Non-Urgent					
Crossing Status: Found					
UCIP Comments: Sediment buildup in pipe visible from landward side--recommend contacting owner to clear pipe.					
FIELD_STRUCT_DESC: 24-inch CM stormdrain pipe through the levee, 10.2-feet below the crown. Flap gate on the waterward end. Concrete headwalls on the landward end with flashboards. Concrete saddle and apron on the waterward end with a flapgate. Metal screen at LS toe inlet (USACE-1967). This entry matches the Drainage or Irrigation Structure referenced in O&M manual (HLM 12.87).					
FS Date: 4/22/2014

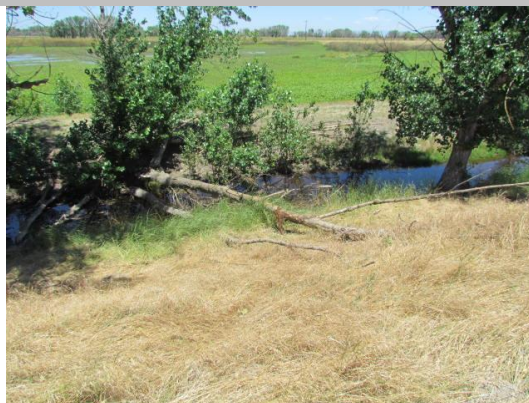
Photo 1 of 1 : SP_2017_NA0010_123_2_20170417_00001.jpg

LM Start	13.01	Rating **	M	Issue No.	2
LM End	13.01	Issue Type +	Ma	Location *	LS
Category	Earthen Levee			GPS Latitude/Longitude	
				Start	End
Item	Encroachments			37.175576 °	37.175576 °
				-120.638755 °	-120.638755 °
DWR ID	DWR_NA0010_05_s_2016_2				
Comment Code					
TR : Tree or limb					
Inspector Comment					
Downed tree on landward toe.

Looking west at down tree at landward toe.

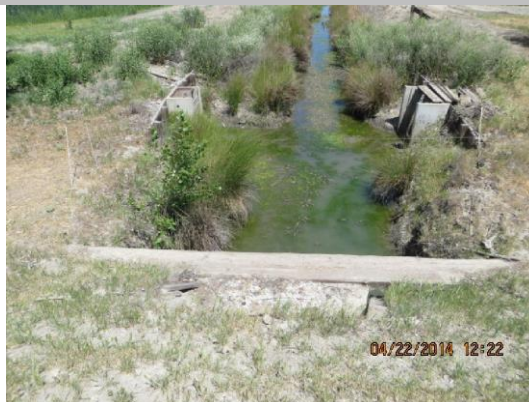
Photo 1 of 3 : UCIP_SP_2017_34288_62244.jpg

LM Start	13.42	Rating **	M	Issue No.	1340
LM End	13.42	Issue Type +	Ma	Location *	LS
Category	Supplemental			GPS Latitude/Longitude	
				Start	End
Item	DWR UCIP LMA Responsibility			37.171523 °	37.171523 °
				-120.633442 °	-120.633442 °
DWR ID					
Comment Code					
Inspector Comment					
FS_ID:34288 DS_ID:19708 EP_NO: N/A Repair Type: Non-Urgent Crossing Status: Found UCIP Comments: Some erosion around headwall on the WS toe and there are animal burrows on both slopes. FIELD_STRUCT_DESC: 48-inch C.M. stormdrain pipe through the levee, 10.0-feet below the crown. Flap gate on the waterward end. Flashboard attachment in concrete "U" headwall on the landward end. Concrete "U" headwall on the waterward end. (USACE-1967). This entry matches the Drainage or Irrigation Structure referenced in O&M manual (HLM 13.40). FS Date: 4/22/2014

Headwall and pipe on LS toe.

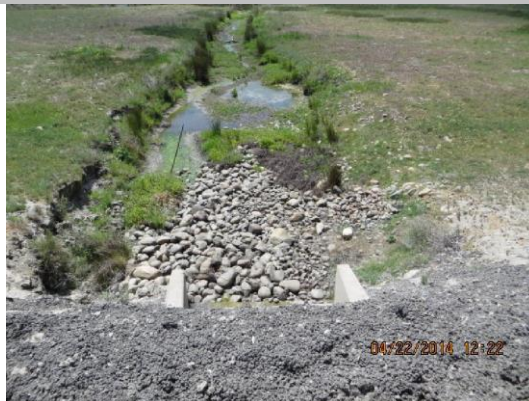
Photo 2 of 3 : UCIP_SP_2017_34288_62243.jpg

LM Start	13.42	Rating **	M	Issue No.	1340 (cont)
LM End	13.42	Issue Type +	Ma	Location *	LS
Category	Supplemental			GPS Latitude/Longitude	
				Start	End
Item	DWR UCIP LMA Responsibility			37.171523 °	37.171523 °
				-120.633442 °	-120.633442 °
DWR ID					
Comment Code					
Inspector Comment					
FS_ID:34288 DS_ID:19708 EP_NO: N/A Repair Type: Non-Urgent Crossing Status: Found UCIP Comments: Some erosion around headwall on the WS toe and there are animal burrows on both slopes. FIELD_STRUCT_DESC: 48-inch C.M. stormdrain pipe through the levee, 10.0-feet below the crown. Flap gate on the waterward end. Flashboard attachment in concrete "U" headwall on the landward end. Concrete "U" headwall on the waterward end. (USACE-1967). This entry matches the Drainage or Irrigation Structure referenced in O&M manual (HLM 13.40). FS Date: 4/22/2014

Headwall, flapgate, and pipe on WS toe.

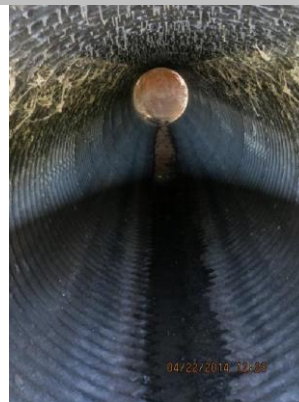
Photo 3 of 3 : UCIP_SP_2017_34288_62242.jpg

LM Start	13.42	Rating **	M	Issue No.	1340 (cont)
LM End	13.42	Issue Type +	Ma	Location *	LS

Headwall, flapgate, and pipe on WS toe.

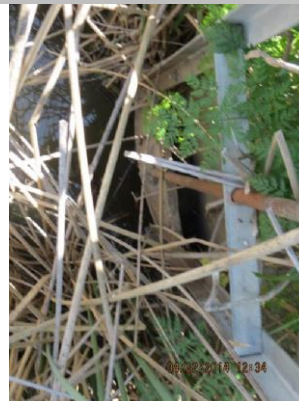
Photo 1 of 2 : UCIP_SP_2017_34824_62624.jpg

FS_ID:34824
 DS_ID:19709
 EP_NO: N/A
 Repair Type: Non-Urgent
 Crossing Status: Found
 UCIP Comments: Pipe not visible and may need to have silt removed from outlet on WS toe.
 FIELD_STRUCT_DESC: 24-inch C.M. stormdrain pipe through the levee, 16-feet below the crown. Flap gate on the waterward end. Slidegate on concrete headwall at LS toe. Concrete saddle and apron on the waterward end. (USACE-1967). This entry matches the Drainage or Irrigation Structure referenced in O&M manual (HLM 13.72).
 FS Date: 4/22/2014

Slide gate at concrete headwall on LS toe.

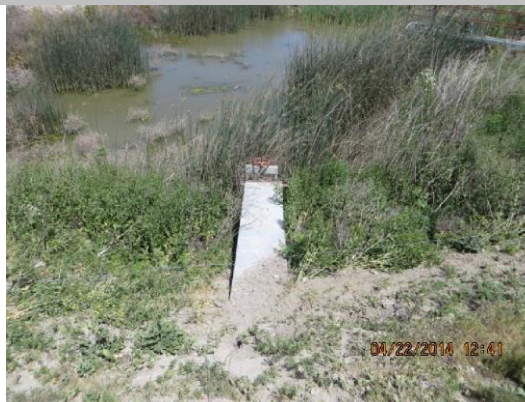
Photo 2 of 2 : UCIP_SP_2017_34824_62623.jpg

Walkway to gatevalve on LS shoulder.

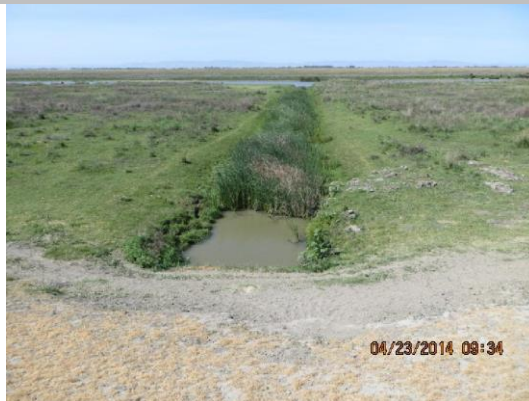
Photo 1 of 3 : UCIP_SP_2017_34657_62450.jpg

LM Start	13.85	Rating **	A/W	Issue No.	1342
LM End	13.85	Issue Type +	Ma	Location *	LS
Category	Supplemental			GPS Latitude/Longitude	
				Start	End
Item	DWR UCIP LMA Responsibility			37.166760 °	37.166760 °
				-120.628304 °	-120.628304 °
DWR ID					
Comment Code					
Inspector Comment					
FS_ID:34657 DS_ID:19710 EP_NO: N/A Repair Type: No Action Needed Crossing Status: Found UCIP Comments: FIELD_STRUCT_DESC: 24-inch C.M. stormdrain pipe through the levee, 12.4 feet below the crown. Flap gate on the waterward end. Concrete headwall on both ends. (USACE-1967). This entry matches the Drainage or Irrigation Structure referenced in O&M manual (HLM 13.83). FS Date: 4/23/2014 4:17:00 PM

Headwall, flapgate, and pipe on WS toe.

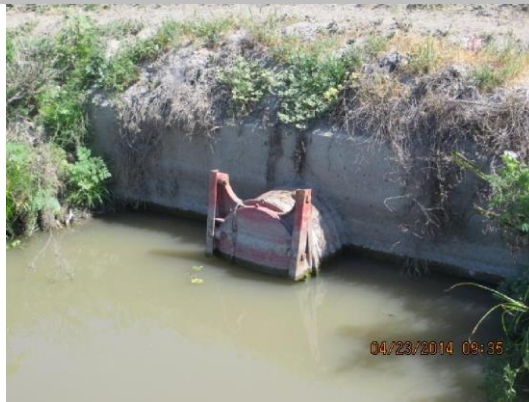
Photo 2 of 3 : UCIP_SP_2017_34657_62448.jpg

LM Start	13.85	Rating **	A/W	Issue No.	1342 (cont)
LM End	13.85	Issue Type +	Ma	Location *	LS

Headwall, flapgate, and pipe on WS toe.

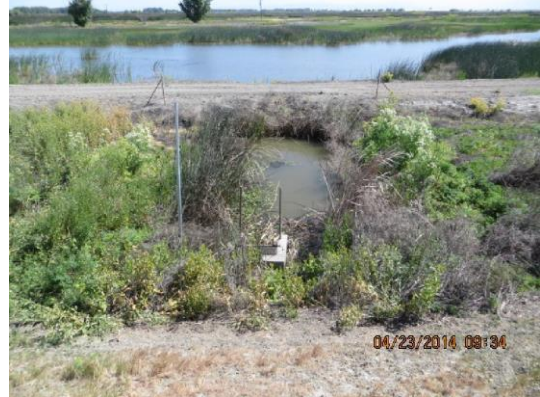
Photo 3 of 3 : UCIP_SP_2017_34657_62449.jpg

LM Start	13.85	Rating **	A/W	Issue No.	1342 (cont)	
LM End	13.85	Issue Type +	Ma	Location *	LS	
Category	Supplemental			GPS Latitude/Longitude		
				Start		End
Item	DWR UCIP LMA Responsibility			37.166760 °		37.166760 °
				-120.628304 °		-120.628304 °
DWR ID						
Comment Code						
Inspector Comment						
FS_ID:34657 DS_ID:19710 EP_NO: N/A Repair Type: No Action Needed Crossing Status: Found UCIP Comments: FIELD_STRUCT_DESC: 24-inch C.M. stormdrain pipe through the levee, 12.4 feet below the crown. Flap gate on the waterward end. Concrete headwall on both ends. (USACE-1967). This entry matches the Drainage or Irrigation Structure referenced in O&M manual (HLM 13.83). FS Date: 4/23/2014 4:17:00 PM

Concrete weir intake structure and pipe at LS toe.

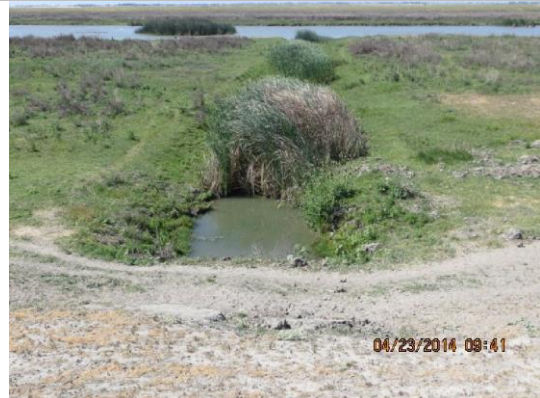
Photo 1 of 3 : UCIP_SP_2017_34656_62446.jpg

LM Start	14.46	Rating **	A/W	Issue No.	1343
LM End	14.46	Issue Type +	Ma	Location *	LS
Category	Supplemental			GPS Latitude/Longitude	
				Start	End
Item	DWR UCIP LMA Responsibility			37.162722 °	37.162722 °
				-120.618571 °	-120.618571 °
DWR ID					
Comment Code					
Inspector Comment					
FS_ID:34656					
DS_ID:19711					
EP_NO: N/A					
Repair Type: No Action Needed					
Crossing Status: Found					
UCIP Comments:					
FIELD_STRUCT_DESC: 24-inch C.M. stormdrain pipe through the levee, 12.5-feet below the crown. Flap gate on the waterward end. Concrete headwall on each end. Concrete weir inlet structure on LS toe (USACE-1967). This entry matches the Drainage or Irrigation Structure referenced in O&M manual (HLM 14.44).					
FS Date: 4/23/2014

Headwall, pipe, and flapgate on WS toe.

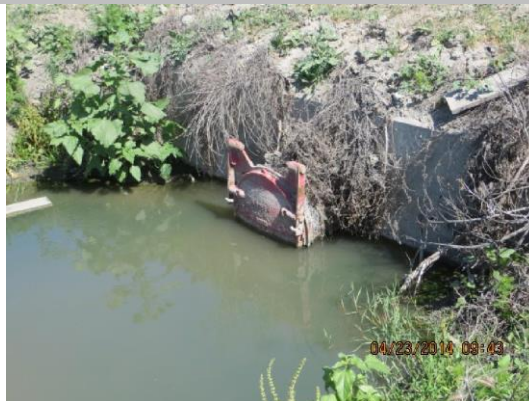
Photo 2 of 3 : UCIP_SP_2017_34656_62447.jpg

LM Start	14.46	Rating **	A/W	Issue No.	1343 (cont)
LM End	14.46	Issue Type +	Ma	Location *	LS
Category	Supplemental			GPS Latitude/Longitude	
				Start	End
Item	DWR UCIP LMA Responsibility			37.162722 °	37.162722 °
				-120.618571 °	-120.618571 °
DWR ID					
Comment Code					
Inspector Comment					
FS_ID:34656 DS_ID:19711 EP_NO: N/A Repair Type: No Action Needed Crossing Status: Found UCIP Comments: FIELD_STRUCT_DESC: 24-inch C.M. stormdrain pipe through the levee, 12.5-feet below the crown. Flap gate on the waterward end. Concrete headwall on each end. Concrete weir inlet structure on LS toe (USACE-1967). This entry matches the Drainage or Irrigation Structure referenced in O&M manual (HLM 14.44). FS Date: 4/23/2014

Headwall, pipe, and flapgate on WS toe.
