**Flood Control Project Maintenance
Levee Inspections**

Maintenance Issue Types Only, Levee Inspection Report By Mile - Spring 2017

Lower San Joaquin Levee District

Waterway	Bank	Unit Miles	Inspection Start/End	Inspector
Unit No. 01 San Joaquin River	Right	22.52	04/17/2017 04/20/2017	Richard Willoughby

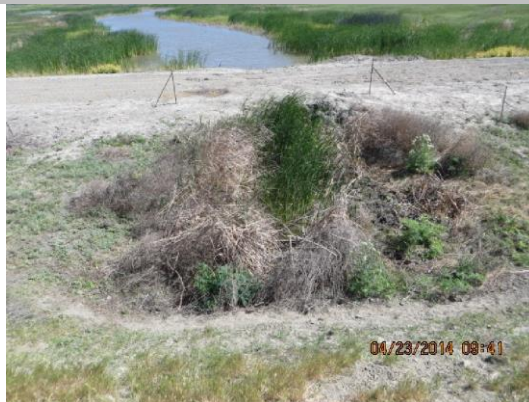
Photo 3 of 3 : UCIP_SP_2017_34656_62445.jpg

LM Start	14.46	Rating **	A/W	Issue No.	1343 (cont)
LM End	14.46	Issue Type +	Ma	Location *	LS

Concrete weir inlet at LS toe.

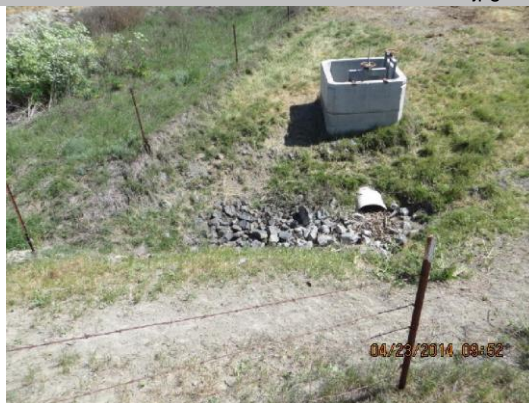
Photo 1 of 3 : UCIP_SP_2017_34664_62454.jpg

LM Start	15.11	Rating **	M	Issue No.	1344
LM End	15.11	Issue Type +	Ma	Location *	LS
Category	Supplemental			GPS Latitude/Longitude	
				Start	End
Item	DWR UCIP LMA Responsibility			37.156805 °	37.156805 °
				-120.609513 °	-120.609513 °
DWR ID					
Comment Code					
Inspector Comment					
FS_ID:34664					
DS_ID:19712					
EP_NO: N/A					
Repair Type: Non-Urgent					
Crossing Status: Found					
UCIP Comments: Minor erosion at headwall on WS toe.					
FIELD_STRUCT_DESC: 36-inch C.M. stormdrain pipe through the					
levee, 11.9 feet below the crown. Flap gate on the waterward end.					
Concrete headwall on both ends. (USACE-1967). This entry matches					
the Drainage or Irrigation Structure referenced in O&M manual (HLM					
15.09).					
FS Date: 4/23/2014

Headwall and inlet on LS toe.

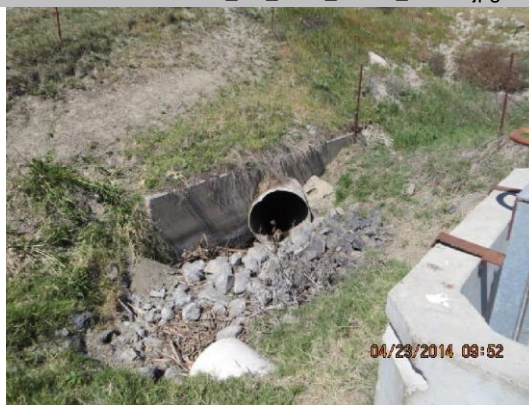
Photo 2 of 3 : UCIP_SP_2017_34664_62453.jpg

LM Start	15.11	Rating **	M	Issue No.	1344 (cont)
LM End	15.11	Issue Type +	Ma	Location *	LS

Headwall and inlet on LS toe.

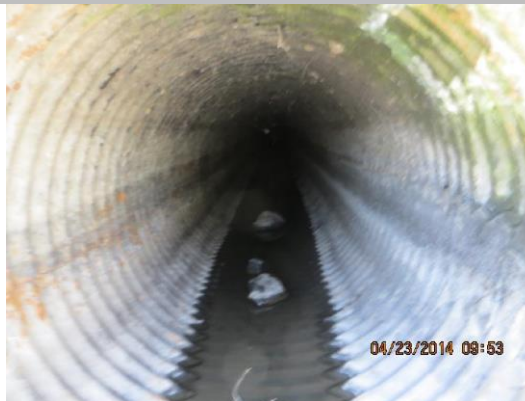
Photo 3 of 3 : UCIP_SP_2017_34664_62452.jpg

LM Start	15.11	Rating **	M	Issue No.	1344 (cont)
LM End	15.11	Issue Type +	Ma	Location *	LS
Category	Supplemental			GPS Latitude/Longitude	
				Start	End
Item	DWR UCIP LMA Responsibility			37.156805 °	37.156805 °
				-120.609513 °	-120.609513 °
DWR ID					
Comment Code					
Inspector Comment					
FS_ID:34664 DS_ID:19712 EP_NO: N/A Repair Type: Non-Urgent Crossing Status: Found UCIP Comments: Minor erosion at headwall on WS toe. FIELD_STRUCT_DESC: 36-inch C.M. stormdrain pipe through the levee, 11.9 feet below the crown. Flap gate on the waterward end. Concrete headwall on both ends. (USACE-1967). This entry matches the Drainage or Irrigation Structure referenced in O&M manual (HLM 15.09). FS Date: 4/23/2014

Inside pipe at LS toe.

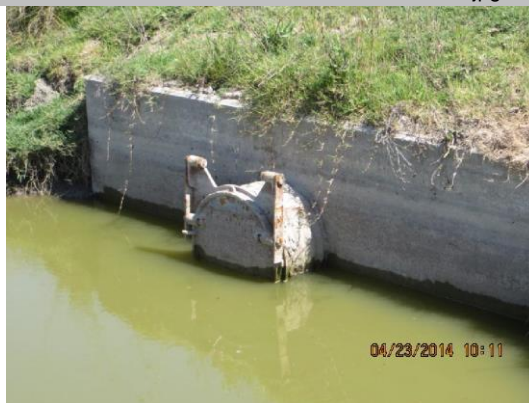
Photo 2 of 3 : UCIP_SP_2017_39596_62467.jpg

LM Start	15.81	Rating **	M	Issue No.	1346 (cont)
LM End	15.81	Issue Type +	Ma	Location *	LS
Category	Supplemental			GPS Latitude/Longitude	
				Start	End
Item	DWR UCIP LMA Responsibility			37.149381 °	37.149381 °
				-120.600761 °	-120.600761 °
DWR ID					
Comment Code					
Inspector Comment					
FS_ID:39596 DS_ID:19715 EP_NO: N/A Repair Type: Non-Urgent Crossing Status: Found UCIP Comments: Excess vegetation at inlet on LS toe should be cleared. FIELD_STRUCT_DESC: 24-inch C.M. stormdrain pipe through the levee, 12-feet below the crown. Flap gate on the waterward end. Concrete head wall on the landward end. Concrete saddle and apron on the waterward end. (USACE-1967). This entry matches the Drainage or Irrigation Structure referenced in O&M manual (HLM 15.80). FS Date: 4/23/2014

Headwall, pipe, and flapgate on WS toe.

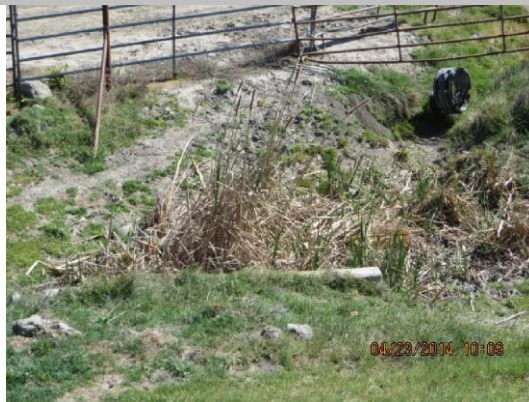
Photo 3 of 3 : UCIP_SP_2017_39596_62466.jpg

LM Start	15.81	Rating **	M	Issue No.	1346 (cont)
LM End	15.81	Issue Type +	Ma	Location *	LS

Headwall and pipe visible at LS toe.

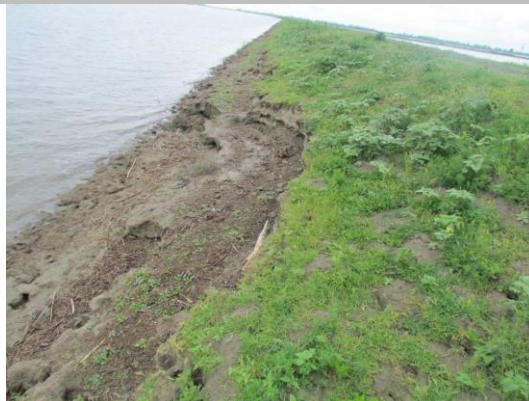
Photo 1 of 2 : SP_2017_NA0010_123_110_20170424_00285.jpg

LM Start	16.11	Rating **	U	Issue No.	110
LM End	16.36	Issue Type +	Ma	Location *	WS
Category	Earthen Levee			GPS Latitude/Longitude	
				Start	End
Item	Erosion / Bank Caving			37.145965 °	37.142963 °
				-120.597597 °	-120.595087 °
DWR ID	DWR_NA0010_05_s_2017_110				
Comment Code					
E2 : Schedule repair of erosion site prior to the next inspection.					
Inspector Comment					
Eight to ten inch erosion on waterward toe.

Looking upstream at erosion on waterward slope.

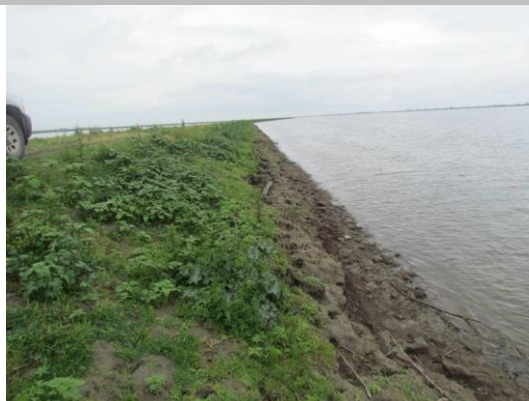
Photo 2 of 2 : SP_2017_NA0010_123_110_20170424_00286.jpg

Looking downstream at erosion on waterward slope.

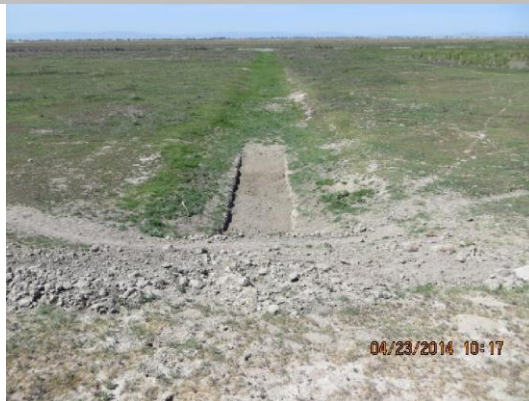
Photo 1 of 3 : UCIP_SP_2017_34725_62469.jpg

LM Start	16.68	Rating **	M	Issue No.	1347
LM End	16.68	Issue Type +	Ma	Location *	WS
Category	Supplemental			GPS Latitude/Longitude	
				Start	End
Item	DWR UCIP LMA Responsibility			37.138760 °	37.138760 °
				-120.592393 °	-120.592393 °
DWR ID					
Comment Code					
Inspector Comment					
FS_ID:34725					
DS_ID:19716					
EP_NO: N/A					
Repair Type: Non-Urgent					
Crossing Status: Found					
UCIP Comments: Pipe heavily silted on LS toe.					
FIELD_STRUCT_DESC: 24-inch C.M. stormdrain pipe through the					
levee, 10.5-feet below the crown. Flap gate on the waterward end.					
Concrete headwall on both ends. (USACE-1967). This entry matches					
the Drainage or Irrigation Structure referenced in O&M manual (HLM					
16.67).					
FS Date: 4/23/2014

Headwall, flapgate, and pipe visible on WS toe.

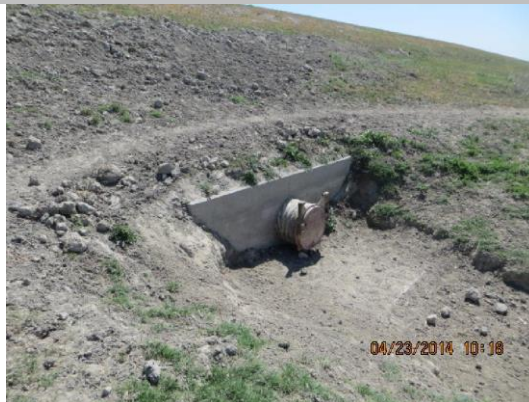
Photo 2 of 3 : UCIP_SP_2017_34725_62471.jpg

Headwall, flapgate, and pipe visible on WS toe.

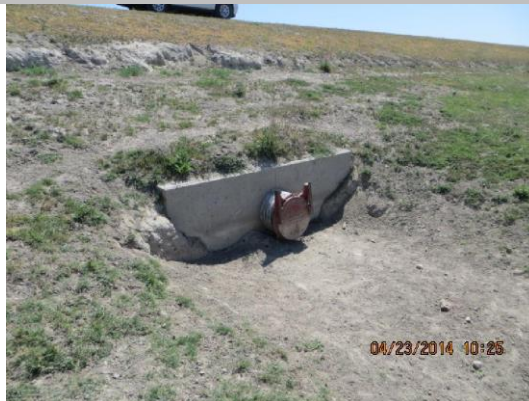
Photo 2 of 3 : UCIP_SP_2017_39597_62483.jpg

Headwall, flapgate, and pipe visible on WS toe.

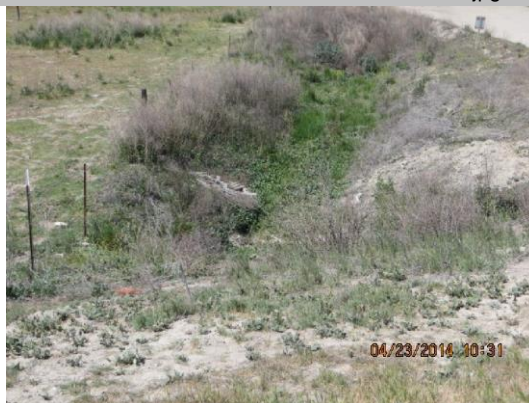
Photo 1 of 3 : UCIP_SP_2017_39599_62485.jpg

FS_ID:39599
DS_ID:19743
EP_NO: N/A
Repair Type: Non-Urgent
Crossing Status: Found
UCIP Comments: Sediment buildup in pipe visible from landward side--recommend contacting owner to clear pipe.
FIELD_STRUCT_DESC: 24-inch CM stormdrain pipe through the levee, 9.8-feet below the crown. Flap gate on the waterward end. Concrete headwall on both ends. (USACE-1967). This entry matches the Drainage or Irrigation Structure referenced in O&M manual (HLM 17.52).
FS Date: 4/23/2014

Headwall, pipe, and flapgate visible on WS toe.

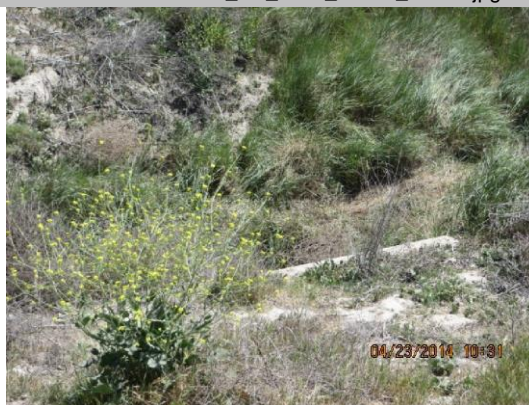
Photo 2 of 3 : UCIP_SP_2017_39599_62486.jpg

Pipe and headwall visible on LS toe.

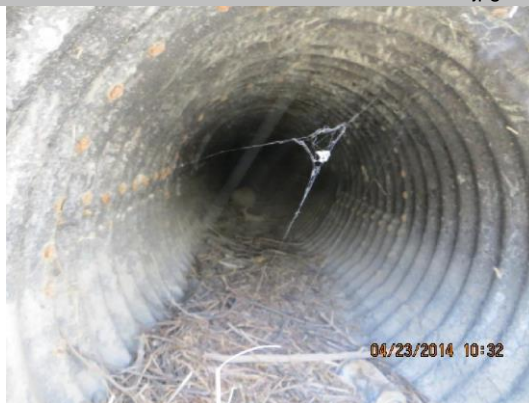
Photo 3 of 3 : UCIP_SP_2017_39599_62488.jpg

Inside pipe on LS toe.

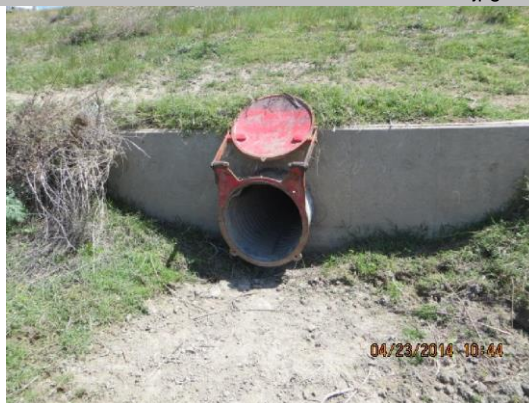
Photo 2 of 3 : UCIP_SP_2017_34747_62495.jpg

Headwall, pipe, and flapgate on WS toe.

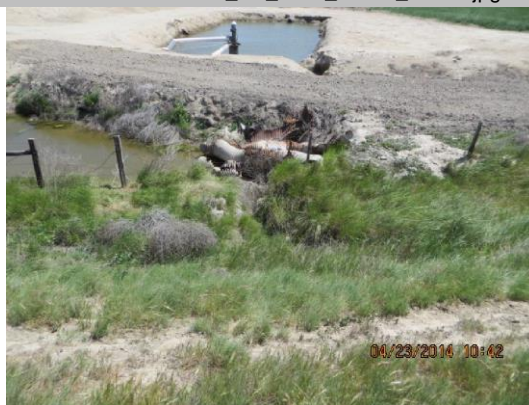
Photo 3 of 3 : UCIP_SP_2017_34747_62493.jpg

Headwall and pipe visible on LS toe.

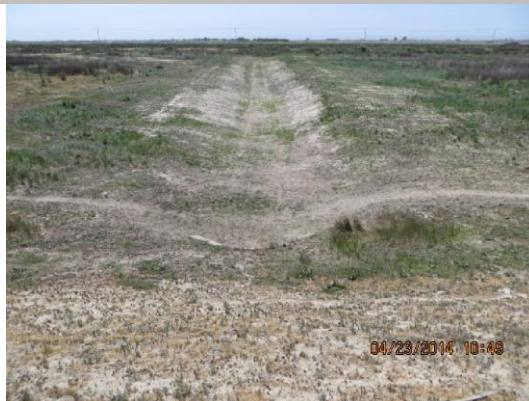
Photo 1 of 3 : UCIP_SP_2017_39600_62499.jpg

FS_ID:39600
DS_ID:19746
EP_NO: N/A
Repair Type: Non-Urgent
Crossing Status: Found
UCIP Comments: Dense vegetation limits the inspector's visibility to identify signs of pipe failure (leaks) along the landward slope. Recommend removing vegetation along pipe alignment to conduct proper inspection of structure.
FIELD_STRUCT_DESC: 24-inch C.M. stormdrain pipe through the levee, 10.0-feet below the crown. Flap gate on the waterward end. Concrete headwall on the landward end. Concrete "U" headwall on the waterward end. (USACE-1967). This entry matches the Drainage or Irrigation Structure referenced in O&M manual (HLM 18.68).
FS Date: 4/23/2014

Headwall, pipe and flapgate visible on WS toe.

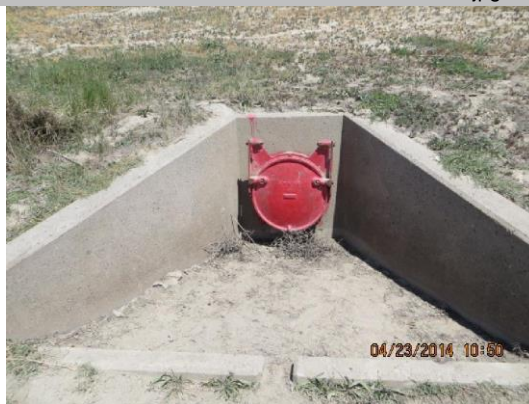
Photo 2 of 3 : UCIP_SP_2017_39600_62498.jpg

Headwall, pipe and flapgate visible on WS toe.

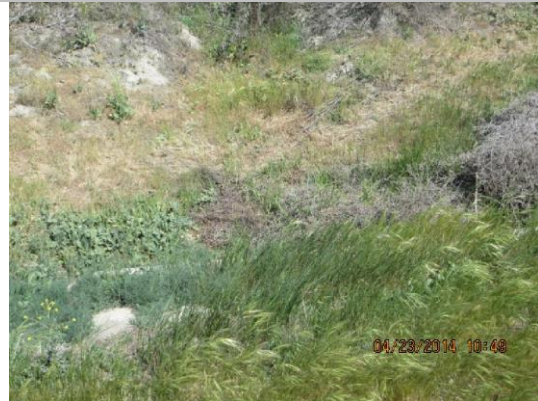
Photo 3 of 3 : UCIP_SP_2017_39600_62500.jpg

Headwall and pipe on LS toe.

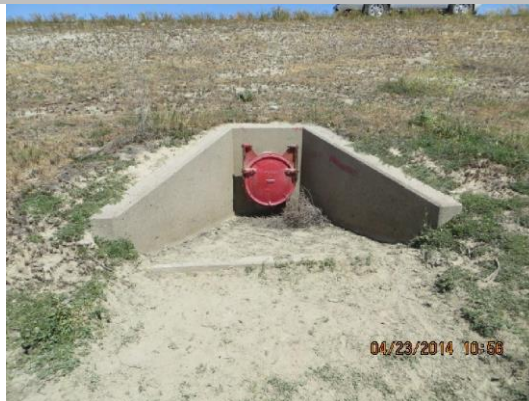
Photo 2 of 3 : UCIP_SP_2017_39601_62506.jpg

Headwall, pipe, and flapgate visible on WS toe.

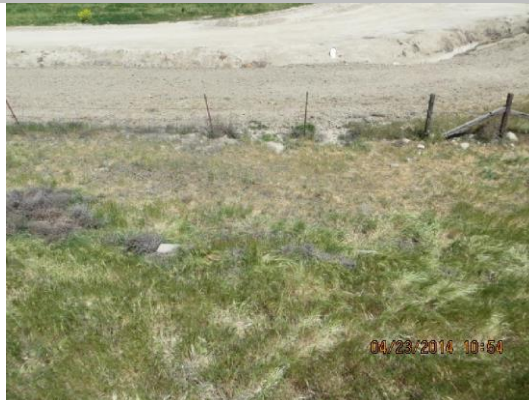
Photo 3 of 3 : UCIP_SP_2017_39601_62505.jpg

Headwall and pipe visible on LS toe.

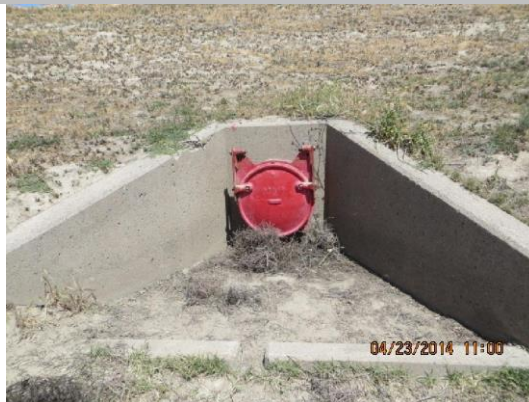
Photo 2 of 3 : UCIP_SP_2017_34751_62511.jpg

Headwall, pipe, and flapgate visible on WS toe.

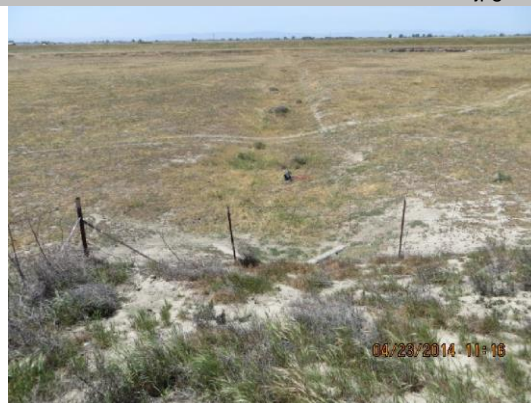
Photo 1 of 3 : UCIP_SP_2017_39603_62519.jpg

FS_ID:39603
DS_ID:19778
EP_NO: N/A
Repair Type: Non-Urgent
Crossing Status: Found
UCIP Comments: Dense vegetation limits the inspector's visibility to identify signs of pipe failure (leaks) along the landward slope. Recommend removing vegetation along pipe alignment to conduct proper inspection of structure. Sediment buildup in pipe visible from landward side--recommend contacting owner to clear pipe.
FIELD_STRUCT_DESC: 24-inch C.M. stormdrain pipe through the levee, 9.7 feet below the crown. Flap gate on the waterward end. Concrete headwall on the landward end. Concrete "U" headwall on the waterward end. (USACE-1967). This entry matches the Drainage or Irrigation Structure referenced in O&M manual (HLM 19.50).
FS Date: 4/23/2014

Headwall, pipe, and flapgate visible on WS toe.

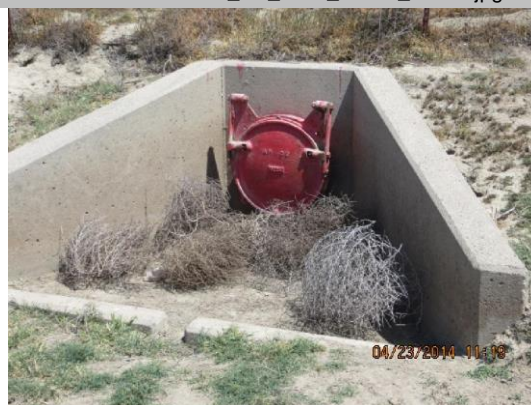
Photo 2 of 3 : UCIP_SP_2017_39603_62521.jpg

Headwall, pipe, and flapgate visible on WS toe.

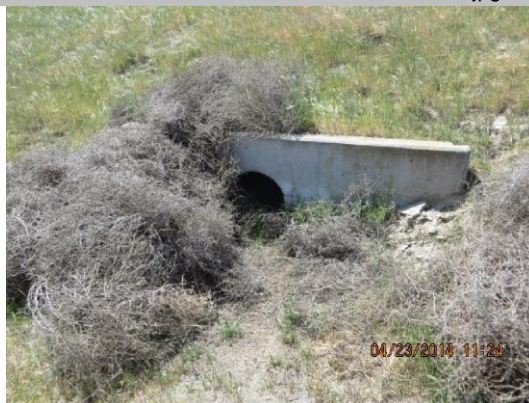
Photo 2 of 3 : UCIP_SP_2017_34754_62524.jpg

Headwall and pipe visible on LS toe.

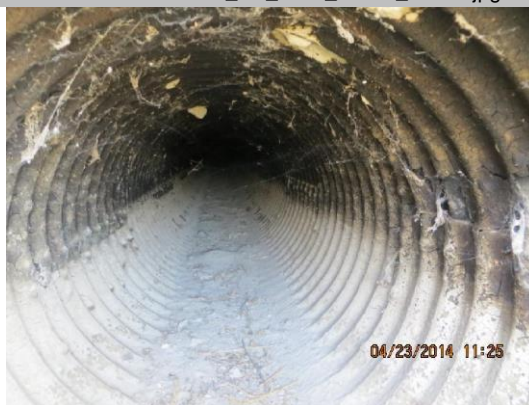
Photo 3 of 3 : UCIP_SP_2017_34754_62523.jpg

Inside pipe on LS toe.

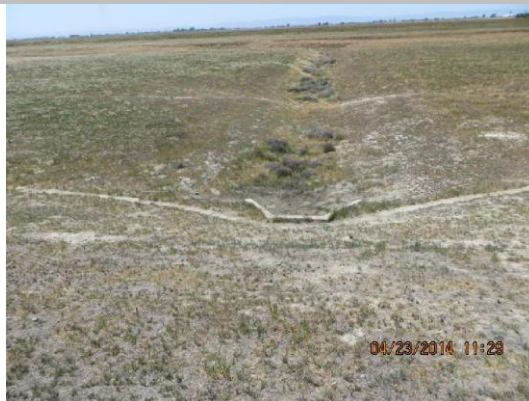
Photo 1 of 3 : UCIP_SP_2017_34755_62529.jpg

LM Start	19.94	Rating **	A/W	Issue No.	1358
LM End	19.94	Issue Type +	Ma	Location *	WS
Category	Supplemental			GPS Latitude/Longitude	
				Start	End
Item	DWR UCIP LMA Responsibility			37.108426 °	37.108426 °
				-120.554990 °	-120.554990 °
DWR ID					
Comment Code					
Inspector Comment					
FS_ID:34755					
DS_ID:19780					
EP_NO: N/A					
Repair Type: No Action Needed					
Crossing Status: Found					
UCIP Comments:					
FIELD_STRUCT_DESC: 36-inch C.M. stormdrain pipe through the					
levee, 9.8-feet below the crown. Flap gate on the waterward end.					
Concrete headwall on the landward end. Concrete "U" headwall on the					
waterward end. (USACE-1967). This entry matches the Drainage or					
Irrigation Structure referenced in O&M manual (HLM 19.92).					
FS Date: 4/23/2014

Headwall, pipe, and flapgate visible on WS toe.

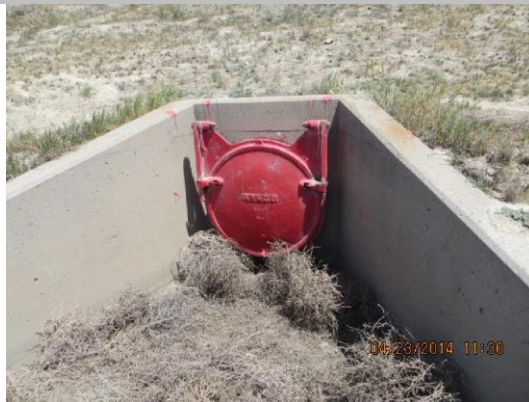
Photo 2 of 3 : UCIP_SP_2017_34755_62530.jpg

LM Start	19.94	Rating **	A/W	Issue No.	1358 (cont)
LM End	19.94	Issue Type +	Ma	Location *	WS

Headwall, pipe, and flapgate visible on WS toe.

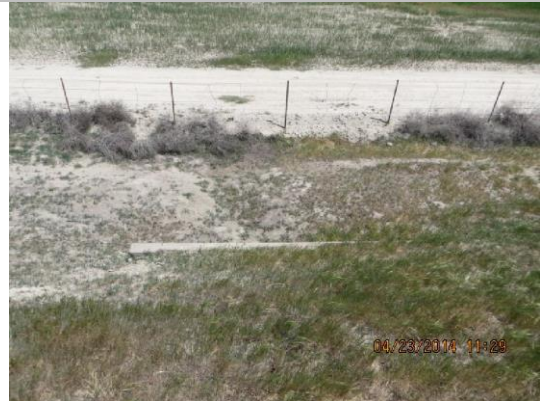
Photo 3 of 3 : UCIP_SP_2017_34755_62528.jpg

LM Start	19.94	Rating **	A/W	Issue No.	1358 (cont)	
LM End	19.94	Issue Type +	Ma	Location *	WS	
Category	Supplemental			GPS Latitude/Longitude		
				Start		End
Item	DWR UCIP LMA Responsibility			37.108426 °		37.108426 °
				-120.554990 °		-120.554990 °
DWR ID						
Comment Code						
Inspector Comment						
FS_ID:34755						
DS_ID:19780						
EP_NO: N/A						
Repair Type: No Action Needed						
Crossing Status: Found						
UCIP Comments:						
FIELD_STRUCT_DESC: 36-inch C.M. stormdrain pipe through the						
levee, 9.8-feet below the crown. Flap gate on the waterward end.						
Concrete headwall on the landward end. Concrete "U" headwall on the						
waterward end. (USACE-1967). This entry matches the Drainage or						
Irrigation Structure referenced in O&M manual (HLM 19.92).						
FS Date: 4/23/2014

Headwall and pipe visible on LS toe.

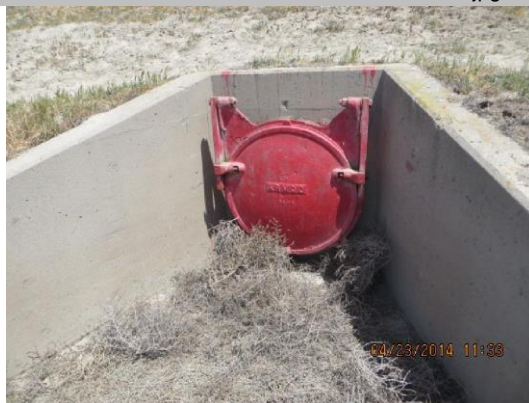
Photo 2 of 3 : UCIP_SP_2017_34757_62532.jpg

LM Start	20.10	Rating **	A/W	Issue No.	1359 (cont)
LM End	20.10	Issue Type +	Ma	Location *	WS
Category	Supplemental			GPS Latitude/Longitude	
				Start	End
Item	DWR UCIP LMA Responsibility			37.107091 °	37.107091 °
				-120.553503 °	-120.553503 °
DWR ID					
Comment Code					
Inspector Comment					
FS_ID:34757					
DS_ID:19781					
EP_NO: N/A					
Repair Type: No Action Needed					
Crossing Status: Found					
UCIP Comments:					
FIELD_STRUCT_DESC: 36-inch C.M. stormdrain pipe through the levee, 9.9-feet below the crown. Flap gate on the waterward end. Concrete headwall on the landward end. Concrete "U" headwall on the waterward end. (USACE-1967). This entry matches the Drainage or Irrigation Structure referenced in O&M manual (HLM 20.05).					
FS Date: 4/23/2014

Headwall, pipe, and flapgate visible on WS toe.

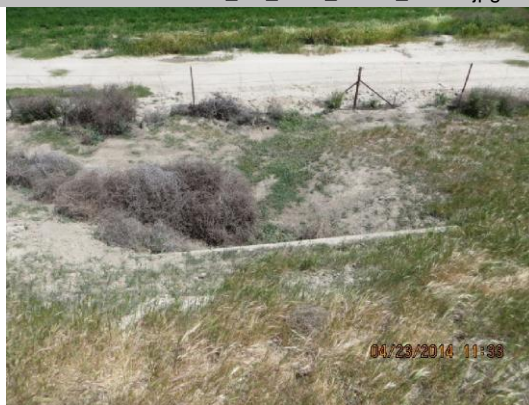
Photo 3 of 3 : UCIP_SP_2017_34757_62534.jpg

Headwall and pipe visible on LS toe.

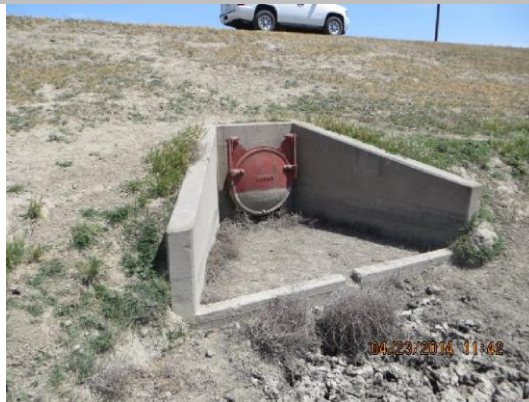
Photo 2 of 3 : UCIP_SP_2017_34760_62541.jpg

Headwall, pipe, and flapgate visible on WS toe.

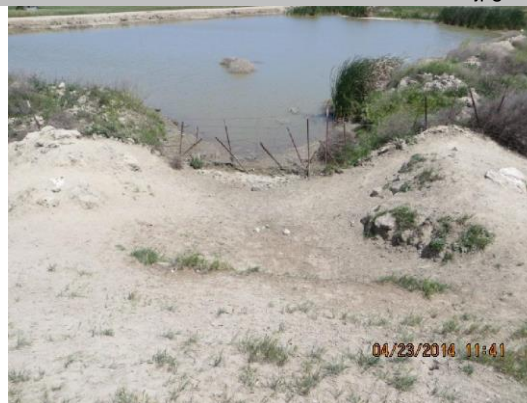
Photo 3 of 3 : UCIP_SP_2017_34760_62540.jpg

LM Start	20.24	Rating **	A/W	Issue No.	1361 (cont)
LM End	20.24	Issue Type +	Ma	Location *	WS
Category	Supplemental			GPS Latitude/Longitude	
				Start	End
Item	DWR UCIP LMA Responsibility			37.105489 °	37.105489 °
				-120.551886 °	-120.551886 °
DWR ID					
Comment Code					
Inspector Comment					
FS_ID:34760					
DS_ID:19783					
EP_NO: N/A					
Repair Type: No Action Needed					
Crossing Status: Found					
UCIP Comments:					
FIELD_STRUCT_DESC: 36-inch C.M. stormdrain pipe through the levee, 10.6-feet below the crown. Flap gate on the waterward end. Concrete headwall on both sides (USACE-1967). This entry matches the Drainage or Irrigation Structure referenced in O&M manual (HLM 20.18).					
FS Date: 4/23/2014

Headwall and pipe visible on LS toe.

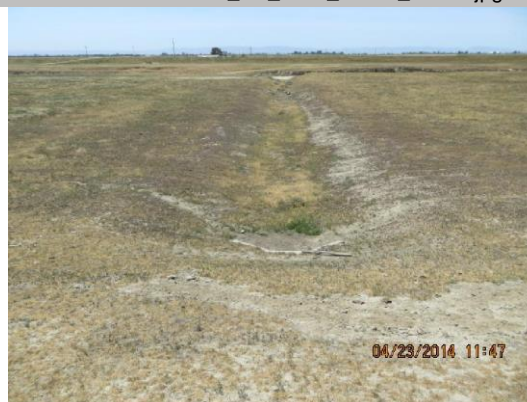
Photo 1 of 3 : UCIP_SP_2017_39605_62544.jpg

Comment Code					
Inspector Comment					
FS_ID:39605					
DS_ID:19784					
EP_NO: N/A					
Repair Type: Non-Urgent					
Crossing Status: Found					
UCIP Comments: Dense vegetation limits the inspector's visibility to identify signs of pipe failure (leaks) along the landward slope.					
Recommend removing vegetation along pipe alignment to conduct proper inspection of structure.					
FIELD_STRUCT_DESC: 24-inch C.M. pipe through the levee, 10.5 feet below the crown. Flap gate on the waterward end. Concrete headwall on the landward end. Concrete "U" headwall on the waterward end. (USACE-1967). This entry matches the Drainage or Irrigation Structure referenced in O&M manual (HLM 20.59).					
FS Date: 4/23/2014

Headwall, pipe, and flapgate visible on WS toe.

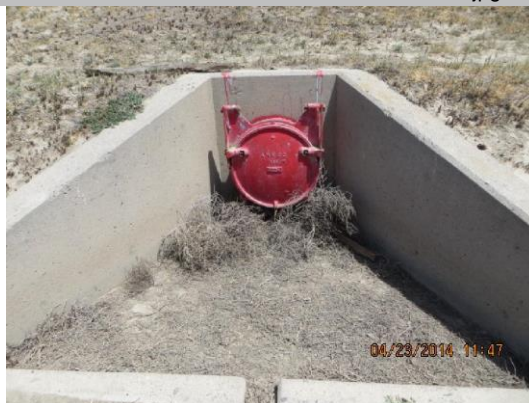
Photo 2 of 3 : UCIP_SP_2017_39605_62543.jpg

FS_ID:39605
DS_ID:19784
EP_NO: N/A
Repair Type: Non-Urgent
Crossing Status: Found
UCIP Comments: Dense vegetation limits the inspector's visibility to identify signs of pipe failure (leaks) along the landward slope. Recommend removing vegetation along pipe alignment to conduct proper inspection of structure.
FIELD_STRUCT_DESC: 24-inch C.M. pipe through the levee, 10.5 feet below the crown. Flap gate on the waterward end. Concrete headwall on the landward end. Concrete "U" headwall on the waterward end. (USACE-1967). This entry matches the Drainage or Irrigation Structure referenced in O&M manual (HLM 20.59).
FS Date: 4/23/2014

Headwall, pipe, and flapgate visible on WS toe.

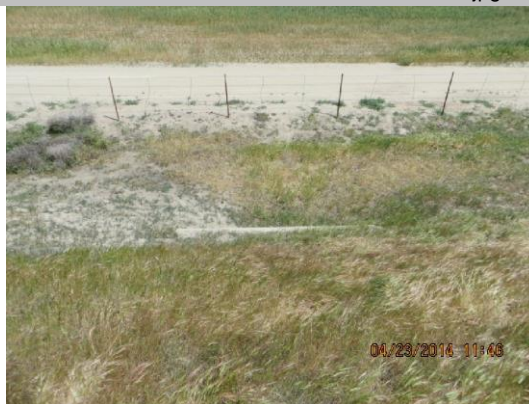
Photo 3 of 3 : UCIP_SP_2017_39605_62545.jpg

Headwall and pipe visible on LS toe.

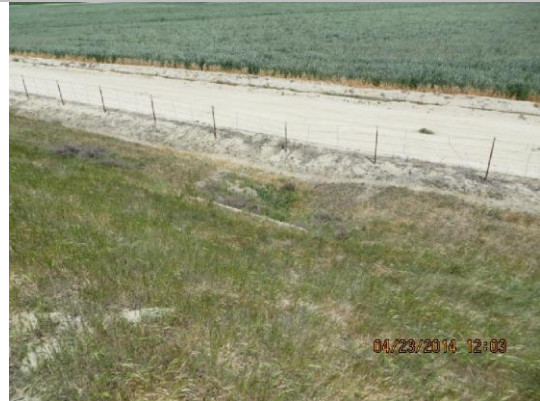
Photo 3 of 3 : UCIP_SP_2017_39606_62550.jpg

LM Start	21.13	Rating **	M	Issue No.	1363 (cont)	
LM End	21.13	Issue Type +	Ma	Location *	WS	
Category	Supplemental			GPS Latitude/Longitude		
				Start	End	
Item	DWR UCIP LMA Responsibility			37.095603 °	37.095603 °	
				-120.541593 °	-120.541593 °	
DWR ID						
Comment Code						
Inspector Comment						
FS_ID:39606						
DS_ID:19785						
EP_NO: N/A						
Repair Type: Non-Urgent						
Crossing Status: Found						
UCIP Comments: Dense vegetation limits the inspector's visibility to proper inspection of structure.						
FIELD_STRUCT_DESC: 24-inch C.M. stormdrain pipe through the levee, 11.8-feet below the crown. Flap gate on the waterward end. Concrete headwall on the landward end. Concrete "U" headwall on the waterward end. (USACE-1967). This entry matches the Drainage or Irrigation Structure referenced in O&M manual (HLM 21.08).						
FS Date: 4/23/2014

Headwall and pipe visible on LS toe.

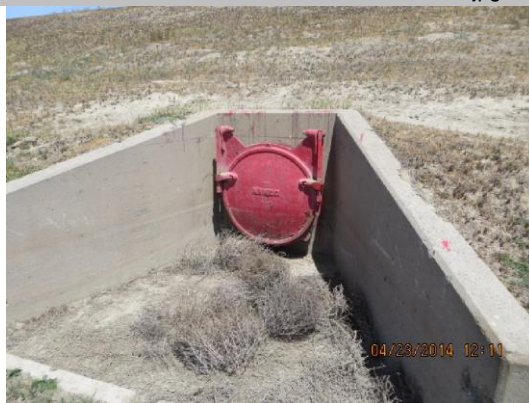
Photo 2 of 3 : UCIP_SP_2017_39614_62556.jpg

FS_ID:39614
DS_ID:19786
EP_NO: N/A
Repair Type: Non-Urgent
Crossing Status: Found
UCIP Comments: Dense vegetation limits the inspector's visibility to identify signs of pipe failure (leaks) along the landward slope. Recommend removing vegetation along pipe alignment to conduct proper inspection of structure.
FIELD_STRUCT_DESC: 36-inch C.M. stormdrain pipe through the levee, 12.7-feet below the crown. Flap gate on the waterward end. Concrete headwall on the landward end. Concrete "U" headwall on the waterward end. (USACE-1967). This entry matches the Drainage or Irrigation Structure referenced in O&M manual (HLM 21.42).
FS Date: 4/23/2014

Headwall, pipe, and flapgate visible on WS toe.

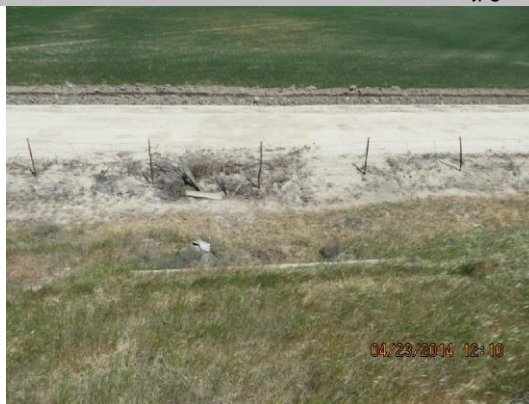
Photo 3 of 3 : UCIP_SP_2017_39614_62554.jpg

Headwall and pipe visible on LS toe.

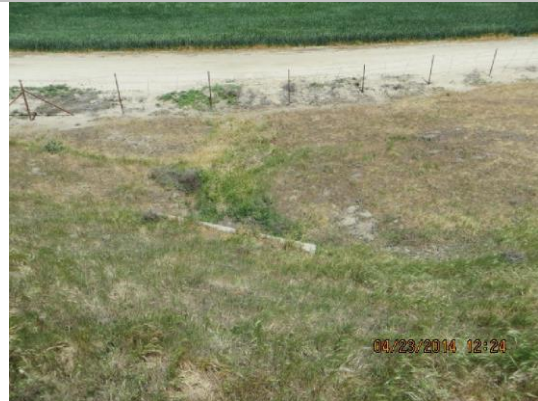
Photo 3 of 3 : UCIP_SP_2017_39883_62560.jpg

LM Start	21.91	Rating **	M	Issue No.	1365 (cont)	
LM End	21.91	Issue Type +	Ma	Location *	WS	
Category	Supplemental			GPS Latitude/Longitude		
				Start	End	
Item	DWR UCIP LMA Responsibility			37.087525 °	37.087525 °	
				-120.532827 °	-120.532827 °	
DWR ID						
Comment Code						
Inspector Comment						
FS_ID:39883						
DS_ID:19787						
EP_NO: N/A						
Repair Type: Non-Urgent						
Crossing Status: Found						
UCIP Comments: Dense vegetation limits the inspector's visibility to proper inspection of structure.						
FIELD_STRUCT_DESC: 24-inch C.M. stormdrain pipe through the levee, 12.4-feet below the crown. Flap gate on the waterward end. Concrete headwall on the landward end. Concrete "U" headwall on the waterward end. (USACE-1967). This entry matches the Drainage or Irrigation Structure referenced in O&M manual (HLM 21.81).						
FS Date: 4/23/2014

Headwall and pipe visible on LS toe.

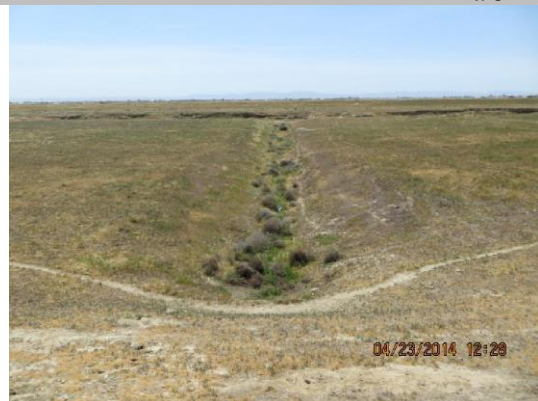
Photo 1 of 3 : UCIP_SP_2017_39610_62586.jpg

Comment Code					
Inspector Comment					
FS_ID:39610 DS_ID:19788 EP_NO: N/A Repair Type: Non-Urgent Crossing Status: Found UCIP Comments: Dense vegetation limits the inspector's visibility to identify signs of pipe failure (leaks) along the landward slope. Recommend removing vegetation along pipe alignment to conduct proper inspection of structure. FIELD_STRUCT_DESC: 24-inch C.M. stormdrain pipe through the levee, 10.7-feet below the crown. Flap gate on the waterward end. Concrete headwall on the landward end. Concrete "U" headwall on the waterward end. (USACE-1967). This entry matches the Drainage or Irrigation Structure referenced in O&M manual (HLM 21.85). ES Date: 4/23/2014

Headwall, pipe, and flapgate visible on WS toe.

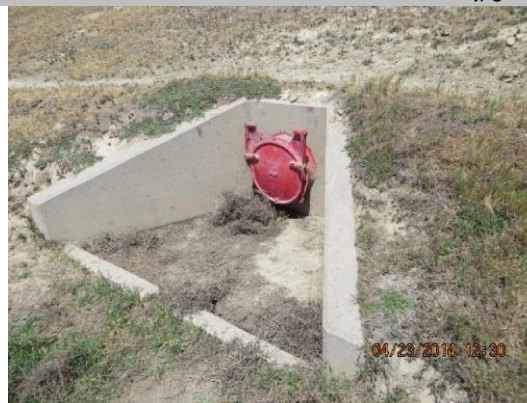
Photo 2 of 3 : UCIP_SP_2017_39610_62588.jpg

Item	DWR UCIP LMA Responsibility			37.087108 °	37.087108 °	
				-120.532374 °	-120.532374 °	
DWR ID						
Comment Code						
Inspector Comment						
FS_ID:39610 DS_ID:19788 EP_NO: N/A Repair Type: Non-Urgent Crossing Status: Found UCIP Comments: Dense vegetation limits the inspector's visibility to identify signs of pipe failure (leaks) along the landward slope. Recommend removing vegetation along pipe alignment to conduct proper inspection of structure. FIELD_STRUCT_DESC: 24-inch C.M. stormdrain pipe through the levee, 10.7-feet below the crown. Flap gate on the waterward end. Concrete headwall on the landward end. Concrete "U" headwall on the waterward end. (USACE-1967). This entry matches the Drainage or Irrigation Structure referenced in O&M manual (HLM 21.85). FS Date: 4/23/2014

Headwall, pipe, and flapgate visible on WS toe.

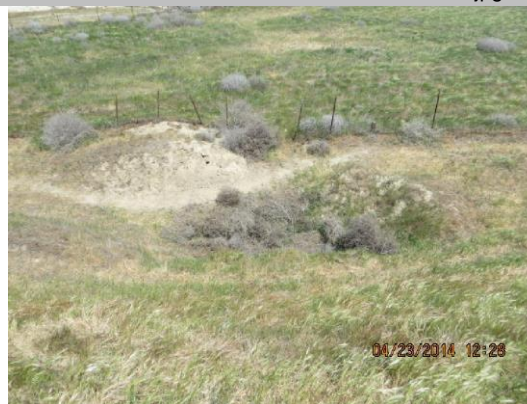
Photo 3 of 3 : UCIP_SP_2017_39610_62587.jpg

Headwall and pipe visible on LS toe.

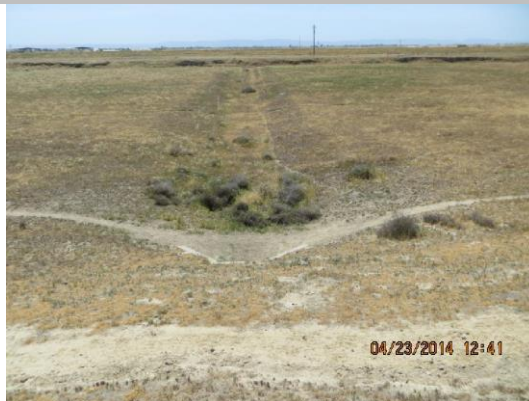
Photo 1 of 3 : UCIP_SP_2017_39611_62591.jpg

FS_ID:39611
DS_ID:19789
EP_NO: N/A
Repair Type: Non-Urgent
Crossing Status: Found
UCIP Comments: Dense vegetation limits the inspector's visibility to identify signs of pipe failure (leaks) along the landward slope. Recommend removing vegetation along pipe alignment to conduct proper inspection of structure. Sediment buildup in pipe visible from landward side--recommend contacting owner to clear pipe.
FIELD_STRUCT_DESC: 24-inch C.M. stormdrain pipe through the levee, 10.2-feet below the crown. Flap gate on the waterward end. Concrete headwall on the landward end. Concrete "U" headwall on the waterward end. (USACE-1967). This entry matches the Drainage or Irrigation Structure referenced in O&M manual (HLM 22.19).
FS Date: 4/23/2014

Headwall, pipe, and flapgate visible on WS toe.

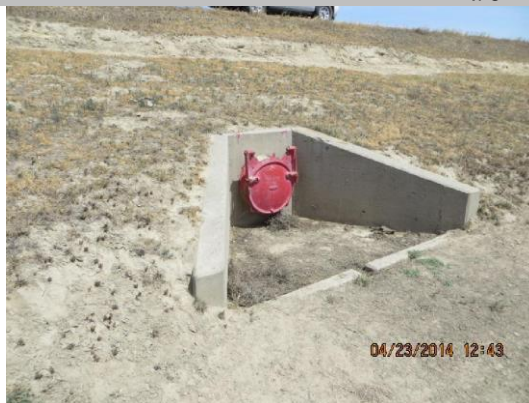
Photo 2 of 3 : UCIP_SP_2017_39611_62593.jpg

Headwall, pipe, and flapgate visible on WS toe.

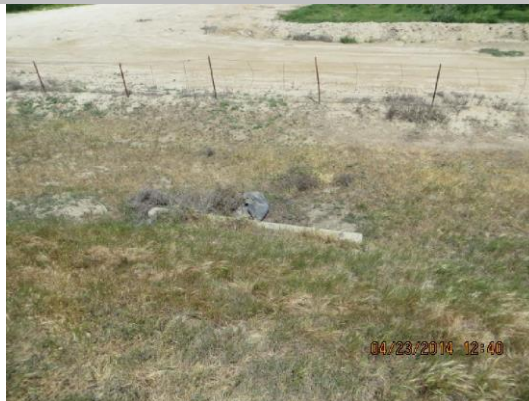
Photo 3 of 3 : UCIP_SP_2017_39611_62592.jpg

FS_ID:39611
DS_ID:19789
EP_NO: N/A
Repair Type: Non-Urgent
Crossing Status: Found
UCIP Comments: Dense vegetation limits the inspector's visibility to identify signs of pipe failure (leaks) along the landward slope. Recommend removing vegetation along pipe alignment to conduct proper inspection of structure. Sediment buildup in pipe visible from landward side--recommend contacting owner to clear pipe.
FIELD_STRUCT_DESC: 24-inch C.M. stormdrain pipe through the levee, 10.2-feet below the crown. Flap gate on the waterward end. Concrete headwall on the landward end. Concrete "U" headwall on the waterward end. (USACE-1967). This entry matches the Drainage or Irrigation Structure referenced in O&M manual (HLM 22.19).
FS Date: 4/23/2014

Headwall and pipe visible on LS toe.

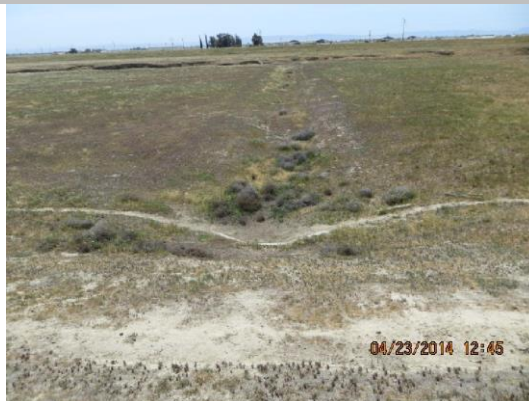
Photo 1 of 3 : UCIP_SP_2017_39613_62596.jpg

FS_ID:39613
DS_ID:19790
EP_NO: N/A
Repair Type: Non-Urgent
Crossing Status: Found
UCIP Comments: Dense vegetation limits the inspector's visibility to identify signs of pipe failure (leaks) along the landward slope. Recommend removing vegetation along pipe alignment to conduct proper inspection of structure. Sediment buildup in pipe visible from landward side--recommend contacting owner to clear pipe.
FIELD_STRUCT_DESC: 24-inch C.M. stormdrain pipe through the levee, 10.4-feet below the crown. Flap gate on the waterward end. Concrete headwall on the landward end. Concrete "U" headwall on the waterward end. (USACE-1967). This entry matches the Drainage or Irrigation Structure referenced in O&M manual (HLM 22.79).
FS Date: 4/23/2014

Headwall, pipe, and flapgate visible on WS toe.

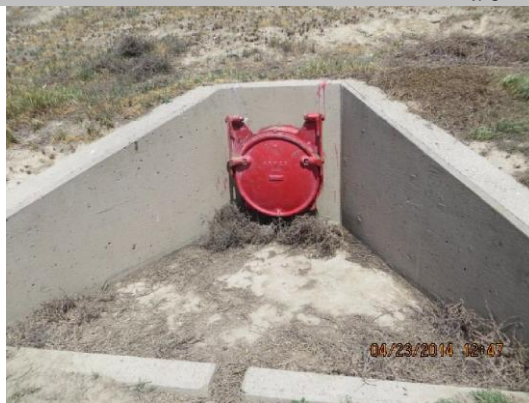
Photo 2 of 3 : UCIP_SP_2017_39613_62598.jpg

Headwall, pipe, and flapgate visible on WS toe.

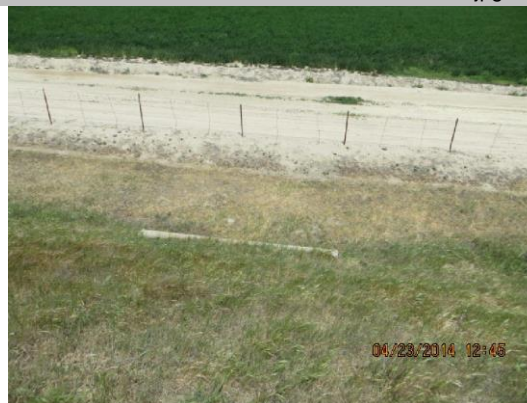
Photo 3 of 3 : UCIP_SP_2017_39613_62597.jpg

Headwall and pipe visible on LS toe.

Comment Code					
Inspector Comment					
FS_ID:39613 DS_ID:19790 EP_NO: N/A Repair Type: Non-Urgent Crossing Status: Found UCIP Comments: Dense vegetation limits the inspector's visibility to identify signs of pipe failure (leaks) along the landward slope. Recommend removing vegetation along pipe alignment to conduct proper inspection of structure. Sediment buildup in pipe visible from landward side--recommend contacting owner to clear pipe. FIELD_STRUCT_DESC: 24-inch C.M. stormdrain pipe through the levee, 10.4-feet below the crown. Flap gate on the waterward end. Concrete headwall on the landward end. Concrete "U" headwall on the waterward end. (USACE-1967). This entry matches the Drainage or Irrigation Structure referenced in O&M manual (HLM 22.79). FS Date: 4/23/2014

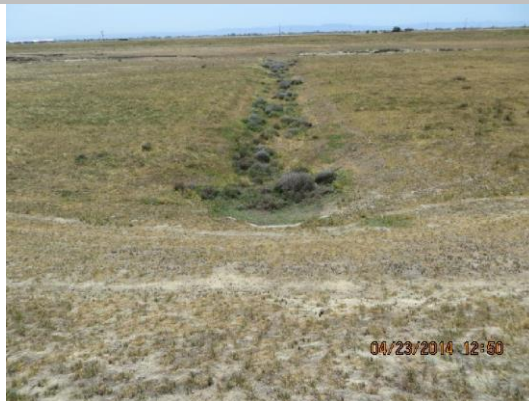
Photo 1 of 3 : UCIP_SP_2017_39616_62601.jpg

FS_ID:39616
DS_ID:19791
EP_NO: N/A
Repair Type: Non-Urgent
Crossing Status: Found
UCIP Comments: Dense vegetation limits the inspector's visibility to identify signs of pipe failure (leaks) along the landward slope. Recommend removing vegetation along pipe alignment to conduct proper inspection of structure. Sediment buildup in pipe visible from landward side--recommend contacting owner to clear pipe.
FIELD_STRUCT_DESC: 24-inch C.M. stormdrain pipe through the levee, 12.2-feet below the crown. Flap gate on the waterward end. Concrete headwall on the landward end. Concrete "U" headwall on the waterward end. (USACE-1967). This entry matches the Drainage or Irrigation Structure referenced in O&M manual (HLM 22.94).
FS Date: 4/23/2014

Headwall, pipe, and flapgate visible on WS toe.

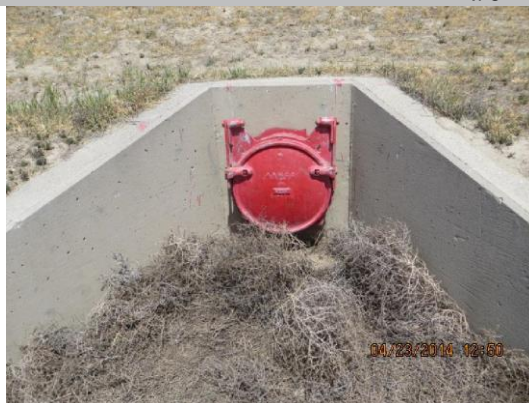
Photo 2 of 3 : UCIP_SP_2017_39616_62600.jpg

Headwall, pipe, and flapgate visible on WS toe.

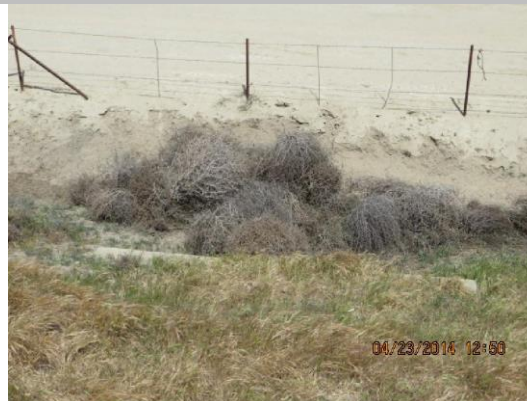
Photo 3 of 3 : UCIP_SP_2017_39616_62602.jpg

Comment Code					
Inspector Comment					
FS_ID:39616					
DS_ID:19791					
EP_NO: N/A					
Repair Type: Non-Urgent					
Crossing Status: Found					
UCIP Comments: Dense vegetation limits the inspector's visibility to identify signs of pipe failure (leaks) along the landward slope.					
Recommend removing vegetation along pipe alignment to conduct proper inspection of structure. Sediment buildup in pipe visible from landward side--recommend contacting owner to clear pipe.					
FIELD_STRUCT_DESC: 24-inch C.M. stormdrain pipe through the levee, 12.2-feet below the crown. Flap gate on the waterward end. Concrete headwall on the landward end. Concrete "U" headwall on the waterward end. (USACE-1967). This entry matches the Drainage or Irrigation Structure referenced in O&M manual (HLM 22.94).					
FS Date: 4/23/2014

Headwall and pipe visible on LS toe.

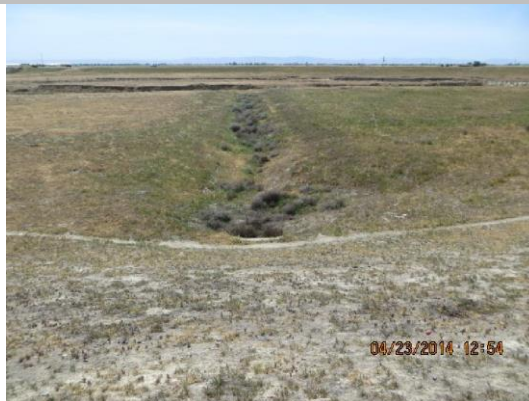
Photo 1 of 3 : UCIP_SP_2017_39617_62606.jpg

FS_ID:39617
DS_ID:19792
EP_NO: N/A
Repair Type: Non-Urgent
Crossing Status: Found
UCIP Comments: Dense vegetation limits the inspector's visibility to identify signs of pipe failure (leaks) along the landward slope. Recommend removing vegetation along pipe alignment to conduct proper inspection of structure.
FIELD_STRUCT_DESC: 24-inch C.M. stormdrain pipe through the levee, 11.1-feet below the crown. Flap gate on the waterward end. Concrete headwall on the landward end. Concrete "U" headwall on the waterward end. (USACE-1967). This entry matches the Drainage or Irrigation Structure referenced in O&M manual (HLM 22.79).
FS Date: 4/23/2014

Headwall, pipe, and flapgate visible on WS toe.

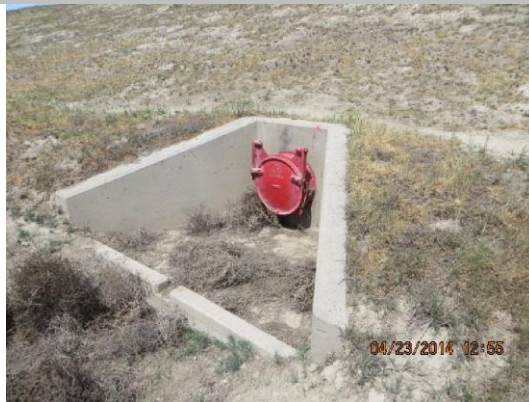
Photo 2 of 3 : UCIP_SP_2017_39617_62608.jpg

Headwall, pipe, and flapgate visible on WS toe.

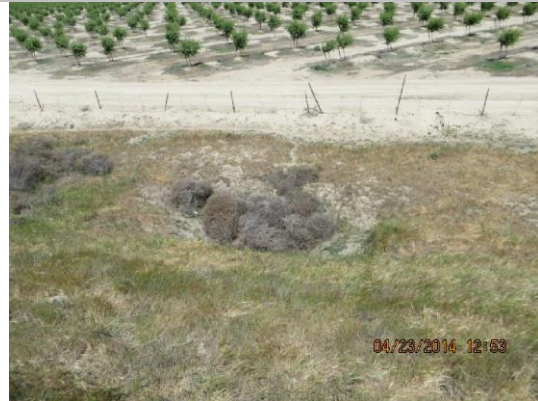
Photo 3 of 3 : UCIP_SP_2017_39617_62607.jpg

LM Start	23.03	Rating **	M	Issue No.	1370 (cont)	
LM End	23.03	Issue Type +	Ma	Location *	WS	
Category	Supplemental			GPS Latitude/Longitude		
				Start	End	
Item	DWR UCIP LMA Responsibility			37.075387 °	37.075387 °	
				-120.519406 °	-120.519406 °	
DWR ID						
Comment Code						
Inspector Comment						
FS_ID:39617						
DS_ID:19792						
EP_NO: N/A						
Repair Type: Non-Urgent						
Crossing Status: Found						
UCIP Comments: Dense vegetation limits the inspector's visibility to proper inspection of structure.						
FIELD_STRUCT_DESC: 24-inch C.M. stormdrain pipe through the levee, 11.1-feet below the crown. Flap gate on the waterward end. Concrete headwall on the landward end. Concrete "U" headwall on the waterward end. (USACE-1967). This entry matches the Drainage or Irrigation Structure referenced in O&M manual (HLM 22.79).						
FS Date: 4/23/2014

Headwall and pipe visible on LS toe.

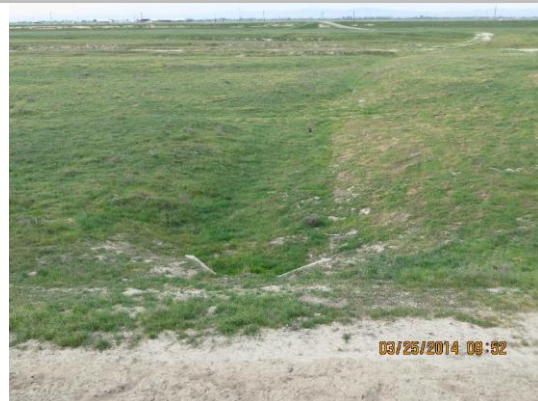
Photo 1 of 3 : UCIP_SP_2017_32763_59262.jpg

LM Start	23.25	Rating **	A/W	Issue No.	1372
LM End	23.25	Issue Type +	Ma	Location *	WS
Category	Supplemental			GPS Latitude/Longitude	
				Start	End
Item	DWR UCIP LMA Responsibility			37.072989 °	37.072989 °
				-120.516687 °	-120.516687 °
DWR ID					
Comment Code					
Inspector Comment					
FS_ID:32763					
DS_ID:19794					
EP_NO: N/A					
Repair Type: No Action Needed					
Crossing Status: Found					
UCIP Comments:					
FIELD_STRUCT_DESC: 30-inch C.M. stormdrain pipe through the					
levee, 11.6 feet below the crown. Flap gate on the waterward end.					
Concrete headwall on the landward end. Concrete "U" headwall on the					
waterward end. (USACE-1967). This entry matches the Drainage or					
Irrigation Structure referenced in O&M manual (HLM 23.15).					
FS Date: 3/25/2014 9:04:45 AM

Concrete headwall on WS toe.

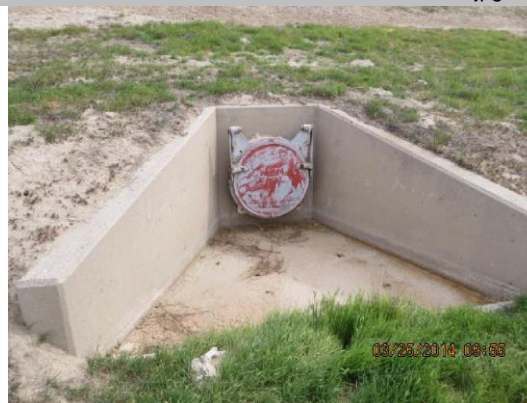
Photo 2 of 3 : UCIP_SP_2017_32763_59263.jpg

LM Start	23.25	Rating **	A/W	Issue No.	1372 (cont)
LM End	23.25	Issue Type +	Ma	Location *	WS
Category	Supplemental			GPS Latitude/Longitude	
				Start	End
Item	DWR UCIP LMA Responsibility			37.072989 °	37.072989 °
				-120.516687 °	-120.516687 °
DWR ID					
Comment Code					
Inspector Comment					
FS_ID:32763					
DS_ID:19794					
EP_NO: N/A					
Repair Type: No Action Needed					
Crossing Status: Found					
UCIP Comments:					
FIELD_STRUCT_DESC: 30-inch C.M. stormdrain pipe through the levee, 11.6 feet below the crown. Flap gate on the waterward end. Concrete headwall on the landward end. Concrete "U" headwall on the waterward end. (USACE-1967). This entry matches the Drainage or Irrigation Structure referenced in O&M manual (HLM 23.15).					
FS Date: 3/25/2014 9:04:45 AM

Flapgate and concrete headwall on WS toe.

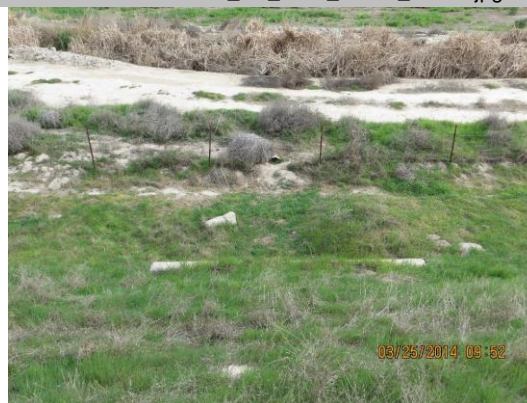
Photo 3 of 3 : UCIP_SP_2017_32763_59261.jpg

Concrete headwall on LS toe.

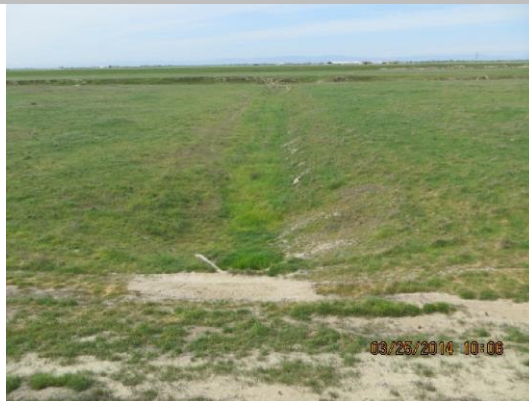
Photo 1 of 3 : UCIP_SP_2017_39621_59272.jpg

FS_ID:39621
DS_ID:19796
EP_NO: N/A
Repair Type: Non-Urgent
Crossing Status: Found
UCIP Comments: Sediment buildup in pipe visible from landward side-- recommend contacting owner to clear pipe.
FIELD_STRUCT_DESC: 30-inch C.M. pipe through the levee, 12.1 feet below the crown. Flap gate on the waterward end. Concrete "U" headwall on the waterward end. (USACE-1967). This entry matches the Drainage or Irrigation Structure referenced in O&M manual (HLM 23.62).
FS Date: 3/25/2014

Concrete headwall on WS toe.

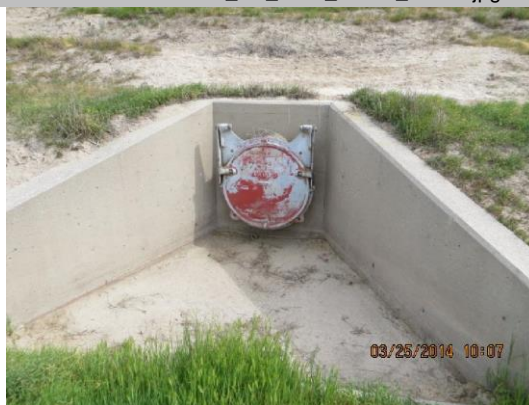
Photo 2 of 3 : UCIP_SP_2017_39621_59270.jpg

Flapgate on Concrete headwall on WS toe.

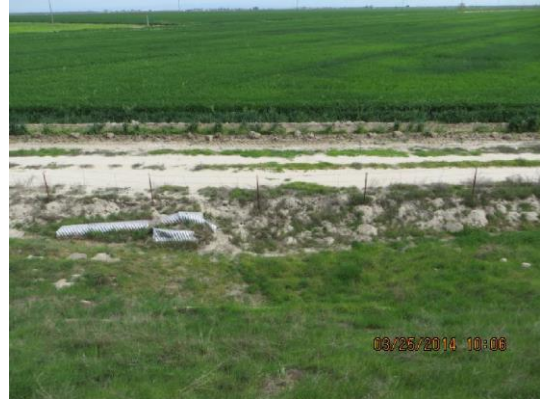
Photo 3 of 3 : UCIP_SP_2017_39621_59271.jpg

LM Start	23.72	Rating **	M	Issue No.	1373 (cont)
LM End	23.72	Issue Type +	Ma	Location *	WS
Category	Supplemental			GPS Latitude/Longitude	
				Start	End
Item	DWR UCIP LMA Responsibility			37.067799 °	37.067799 °
				-120.511093 °	-120.511093 °
DWR ID					
Comment Code					
Inspector Comment					
FS_ID:39621					
DS_ID:19796					
EP_NO: N/A					
Repair Type: Non-Urgent					
Crossing Status: Found					
UCIP Comments: Sediment buildup in pipe visible from landward side--recommend contacting owner to clear pipe.					
FIELD_STRUCT_DESC: 30-inch C.M. pipe through the levee, 12.1 feet below the crown. Flap gate on the waterward end. Concrete "U" headwall on the waterward end. (USACE-1967). This entry matches the Drainage or Irrigation Structure referenced in O&M manual (HLM 23.62).					
FS Date: 3/25/2014

Concrete headwall on LS toe.

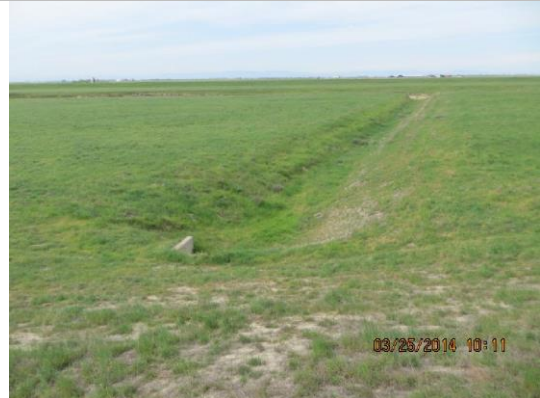
Photo 1 of 3 : UCIP_SP_2017_39620_59282.jpg

LM Start	24.02	Rating **	M	Issue No.	1374
LM End	24.02	Issue Type +	Ma	Location *	WS
Category	Supplemental			GPS Latitude/Longitude	
				Start	End
Item	DWR UCIP LMA Responsibility			37.064494 °	37.064494 °
				-120.507531 °	-120.507531 °
DWR ID					
Comment Code					
Inspector Comment					
FS_ID:39620					
DS_ID:19797					
EP_NO: N/A					
Repair Type: Non-Urgent					
Crossing Status: Found					
UCIP Comments: Minor sediment/debris buildup in pipe visible from landward side--recommend contacting owner to clear pipe.					
FIELD_STRUCT_DESC: 36-inch C.M. stormdrain pipe through the levee, 12.1 feet below the crown. Flap gate on the waterward end.					
Concrete headwall on the landward end. Concrete "U" headwall on the waterward end. (USACE-1967). This entry matches the Drainage or Irrigation Structure referenced in O&M manual (HLM 23.85).					
FS Date: 3/25/2014

Concrete headwall on WS toe.

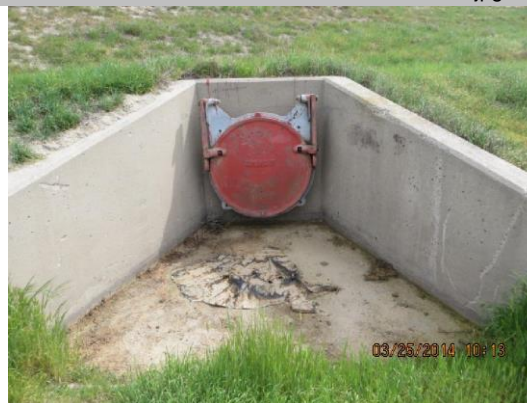
Photo 2 of 3 : UCIP_SP_2017_39620_59280.jpg

FS_ID:39620
DS_ID:19797
EP_NO: N/A
Repair Type: Non-Urgent
Crossing Status: Found
UCIP Comments: Minor sediment/debris buildup in pipe visible from landward side--recommend contacting owner to clear pipe.
FIELD_STRUCT_DESC: 36-inch C.M. stormdrain pipe through the levee, 12.1 feet below the crown. Flap gate on the waterward end. Concrete headwall on the landward end. Concrete "U" headwall on the waterward end. (USACE-1967). This entry matches the Drainage or Irrigation Structure referenced in O&M manual (HLM 23.85).
FS Date: 3/25/2014

Flapgate at Concrete headwall on WS toe.

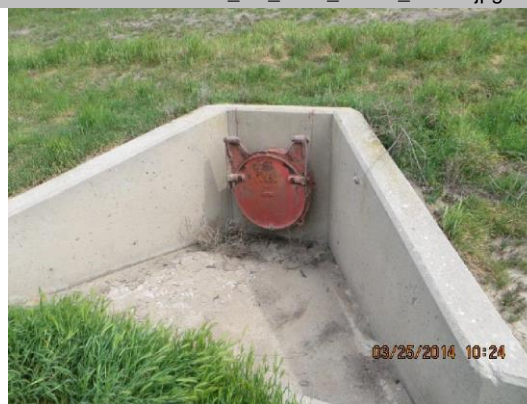
Photo 2 of 3 : UCIP_SP_2017_46850_59285.jpg

FS_ID:46850
DS_ID:19798
EP_NO: N/A
Repair Type: Non-Urgent
Crossing Status: Found
UCIP Comments: Dense vegetation limits the inspector's visibility to identify signs of pipe failure (leaks) along the landward slope. Recommend removing vegetation along pipe alignment to conduct proper inspection of structure.
FIELD_STRUCT_DESC: 24-inch C.M. stormdrain pipe through the levee, 11.2 feet below the crown. Flap gate on the waterward end. Concrete headwall on the landward end. Concrete "U" headwall on the waterward end. (USACE-1967). This entry matches the Drainage or Irrigation Structure referenced in O&M manual (HLM 24.18).
FS Date: 3/25/2014

Flapgate at concrete headwall at WS toe.
