**Flood Control Project Maintenance
Levee Inspections**

Maintenance Issue Types Only, Levee Inspection Report By Mile - Spring 2017

Lower San Joaquin Levee District

Waterway	Bank	Unit Miles	Inspection Start/End	Inspector
Unit No. 01 San Joaquin River	Right	22.52	04/17/2017 04/20/2017	Richard Willoughby

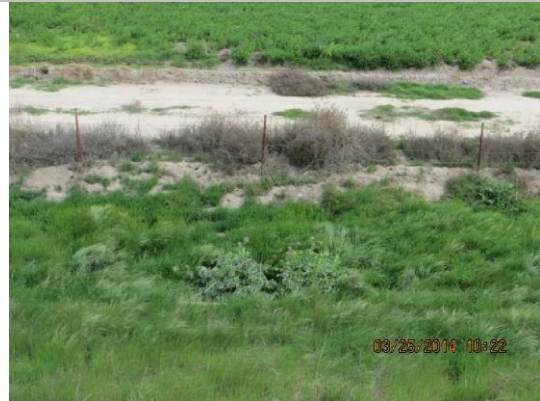
Photo 3 of 3 : UCIP_SP_2017_46850_59286.jpg

Item	DWR UCIP LMA Responsibility			37.061724 °	37.061724 °	
				-120.504512 °	-120.504512 °	
DWR ID						
Comment Code						
Inspector Comment						
FS_ID:46850						
DS_ID:19798						
EP_NO: N/A						
Repair Type: Non-Urgent						
Crossing Status: Found						
UCIP Comments: Dense vegetation limits the inspector's visibility to						
proper signs of pipe failure (leaks) along the landward slope.						
Recommend removing vegetation along pipe alignment to conduct						
proper inspection of structure.						
FIELD_STRUCT_DESC: 24-inch C.M. stormdrain pipe through the						
levee, 11.2 feet below the crown. Flap gate on the waterward end.						
Concrete headwall on the landward end. Concrete "U" headwall on the						
waterward end. (USACE-1967). This entry matches the Drainage or						
Irrigation Structure referenced in O&M manual (HLM 24.18).						
FS Date: 3/25/2014

Concrete headwall at LS toe.

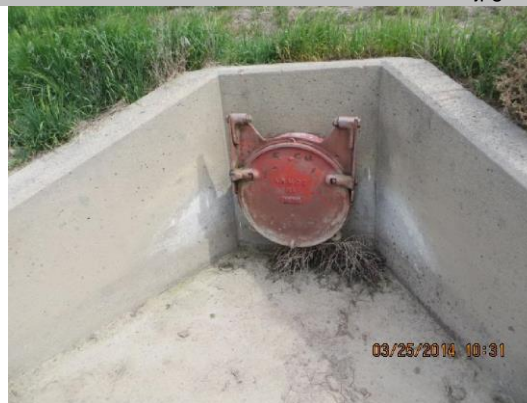
Photo 2 of 3 : UCIP_SP_2017_39623_59290.jpg

FS_ID:39623
DS_ID:19799
EP_NO: N/A
Repair Type: Non-Urgent
Crossing Status: Found
UCIP Comments: Dense vegetation limits the inspector's visibility to identify signs of pipe failure (leaks) along the landward slope. Recommend removing vegetation along pipe alignment to conduct proper inspection of structure.
FIELD_STRUCT_DESC: 24-inch C.M. stormdrain pipe through the levee, 11.2 feet below the crown. Flap gate on the waterward end. Concrete headwall on the landward end. Concrete "U" headwall on the waterward end. (USACE-1967). This entry matches the Drainage or Irrigation Structure referenced in O&M manual (HLM 24.46).
FS Date: 3/25/2014

Flapgate at Concrete headwall on WS toe.

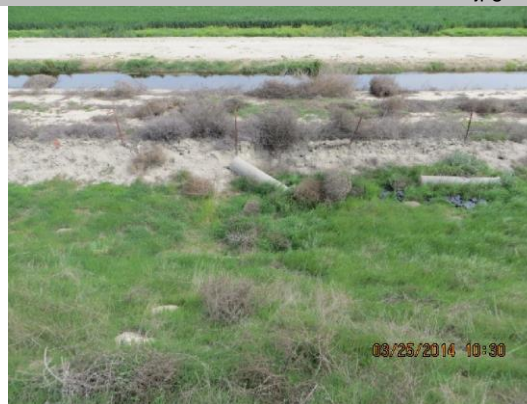
Photo 3 of 3 : UCIP_SP_2017_39623_59291.jpg

Concrete headwall on LS toe.

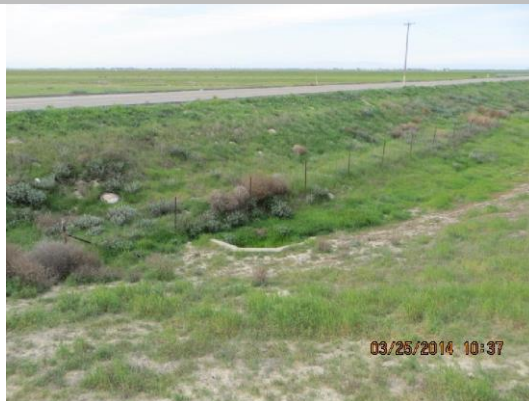
Photo 1 of 3 : UCIP_SP_2017_32786_59297.jpg

LM Start	24.93	Rating **	A/W	Issue No.	1377
LM End	24.93	Issue Type +	Ma	Location *	WS
Category	Supplemental			GPS Latitude/Longitude	
				Start	End
Item	DWR UCIP LMA Responsibility			37.054481 °	37.054481 °
				-120.496798 °	-120.496798 °
DWR ID					
Comment Code					
Inspector Comment					
FS_ID:32786 DS_ID:19800 EP_NO: N/A Repair Type: No Action Needed Crossing Status: Found UCIP Comments: FIELD_STRUCT_DESC: 24-inch C.M. pipe through the levee, 10.7 feet below the crown. Flap gate on the waterward end. Concrete headwall on the landward end. Concrete "U" headwall on the waterward end. (USACE-1967). This entry matches the Drainage or Irrigation Structure referenced in O&M manual (HLM 24.82). FS Date: 3/25/2014

Concrete headwall on WS toe.

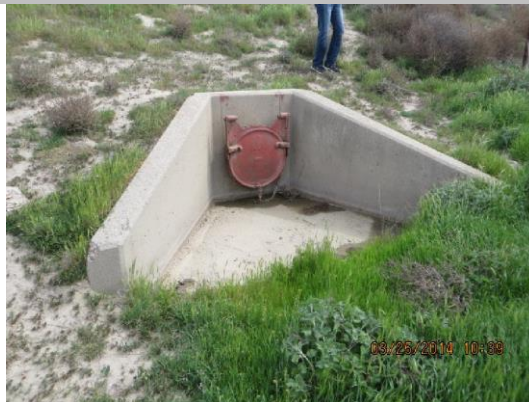
Photo 2 of 3 : UCIP_SP_2017_32786_59295.jpg

Flapgate on concrete headwall on WS toe.

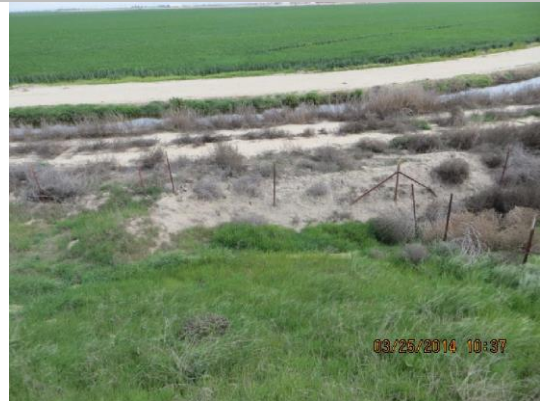
Photo 3 of 3 : UCIP_SP_2017_32786_59296.jpg

LM Start	24.93	Rating **	A/W	Issue No.	1377 (cont)	
LM End	24.93	Issue Type +	Ma	Location *	WS	
Category	Supplemental			GPS Latitude/Longitude		
				Start		End
Item	DWR UCIP LMA Responsibility			37.054481 °	37.054481 °	
				-120.496798 °	-120.496798 °	
DWR ID						
Comment Code						
Inspector Comment						
FS_ID:32786						
DS_ID:19800						
EP_NO: N/A						
Repair Type: No Action Needed						
Crossing Status: Found						
UCIP Comments:						
FIELD_STRUCT_DESC: 24-inch C.M. pipe through the levee, 10.7 feet below the crown. Flap gate on the waterward end. Concrete headwall on the landward end. Concrete "U" headwall on the waterward end. (USACE-1967). This entry matches the Drainage or Irrigation Structure referenced in O&M manual (HLM 24.82).						
FS Date: 3/25/2014

Concrete headwall on LS toe.

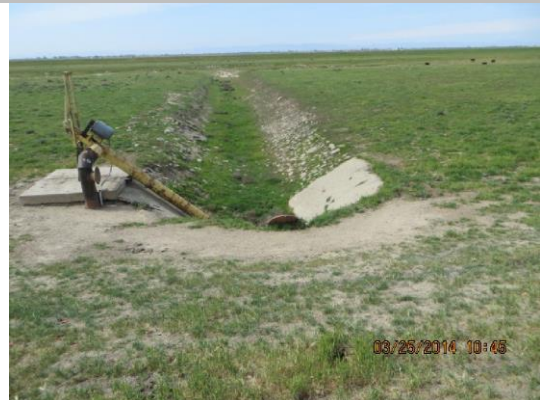
Photo 1 of 3 : UCIP_SP_2017_39624_59302.jpg

LM Start	24.96	Rating **	A/W	Issue No.	1378
LM End	24.96	Issue Type +	Ma	Location *	WS
Category	Supplemental			GPS Latitude/Longitude	
				Start	End
Item	DWR UCIP LMA Responsibility			37.054344 °	37.054344 °
				-120.496214 °	-120.496214 °
DWR ID					
Comment Code					
Inspector Comment					
FS_ID:39624					
DS_ID:19801					
EP_NO: N/A					
Repair Type: No Action Needed					
Crossing Status: Found					
UCIP Comments:					
FIELD_STRUCT_DESC: 30-inch C.M. pipe through the levee, 10.9 feet below the crown. Flap gate on the waterward end. Concrete headwall on the landward end. Concrete "U" headwall on the waterward end. (USACE-1967). This entry matches the Drainage or Irrigation Structure referenced in O&M manual (HLM 24.87).					
FS Date: 3/25/2014

Flapgate and channel off WS toe.

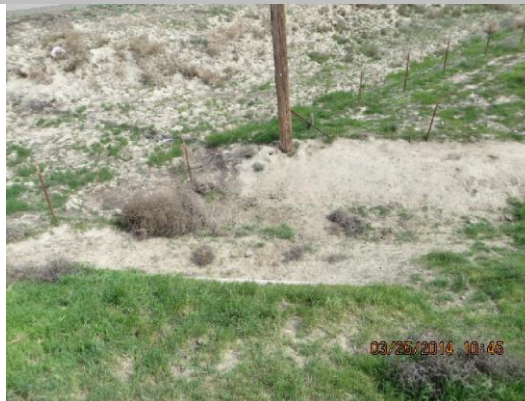
Photo 2 of 3 : UCIP_SP_2017_39624_59301.jpg

LM Start	24.96	Rating **	A/W	Issue No.	1378 (cont)
LM End	24.96	Issue Type +	Ma	Location *	WS
Category	Supplemental			GPS Latitude/Longitude	
				Start	End
Item	DWR UCIP LMA Responsibility			37.054344 °	37.054344 °
				-120.496214 °	-120.496214 °
DWR ID					
Comment Code					
Inspector Comment					
FS_ID:39624					
DS_ID:19801					
EP_NO: N/A					
Repair Type: No Action Needed					
Crossing Status: Found					
UCIP Comments:					
FIELD_STRUCT_DESC: 30-inch C.M. pipe through the levee, 10.9 feet below the crown. Flap gate on the waterward end. Concrete headwall on the landward end. Concrete "U" headwall on the waterward end. (USACE-1967). This entry matches the Drainage or Irrigation Structure referenced in O&M manual (HLM 24.87).					
FS Date: 3/25/2014

Concrete headwall on LS toe.

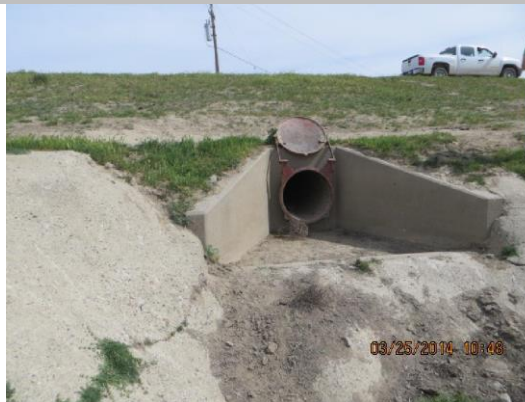
Photo 3 of 3 : UCIP_SP_2017_39624_59303.jpg

Flapgate on headwall at WS toe.

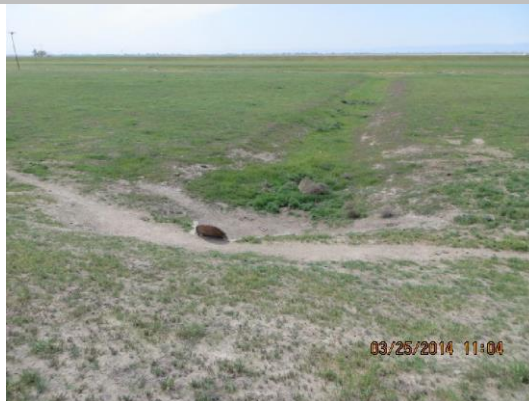
Photo 1 of 3 : UCIP_SP_2017_32789_59311.jpg

LM Start	25.24	Rating **	M	Issue No.	1380
LM End	25.24	Issue Type +	Ma	Location *	WS
Category	Supplemental			GPS Latitude/Longitude	
				Start	End
Item	DWR UCIP LMA Responsibility			37.051477 °	37.051477 °
				-120.492650 °	-120.492650 °
DWR ID					
Comment Code					
Inspector Comment					
FS_ID:32789					
DS_ID:19803					
EP_NO: N/A					
Repair Type: Non-Urgent					
Crossing Status: Found					
UCIP Comments: Flapgate propped open during flood season.					
FIELD_STRUCT_DESC: 30-inch C.M. stormdrain pipe through the					
levee, 11.3 feet below the crown. Flap gate on the waterward end.					
Concrete headwall on the landward end. Concrete "U" headwall on the					
waterward end. (USACE-1967). This entry matches the Drainage or					
Irrigation Structure referenced in O&M manual (HLM 25.13).					
FS Date: 3/25/2014

Concrete headwall and flapgate on WS toe.

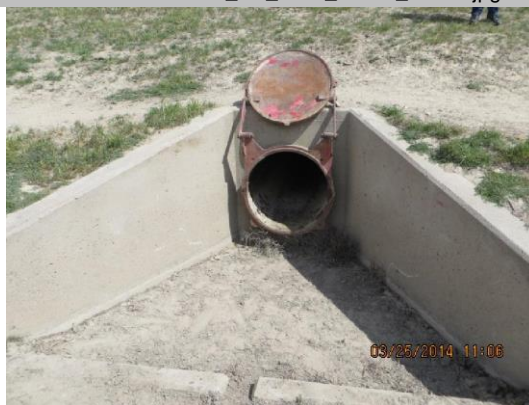
Photo 2 of 3 : UCIP_SP_2017_32789_59312.jpg

Concrete headwall and flapgate on WS toe.

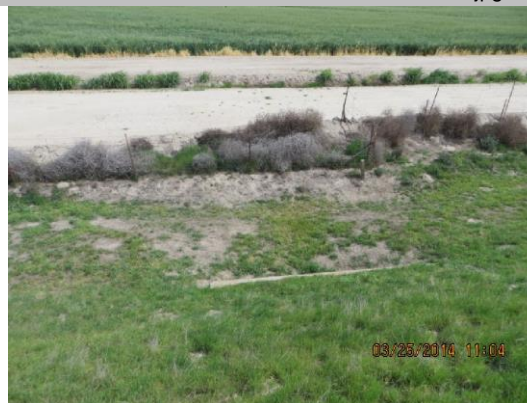
Photo 3 of 3 : UCIP_SP_2017_32789_59310.jpg

LM Start	25.24	Rating **	M	Issue No.	1380 (cont)
LM End	25.24	Issue Type +	Ma	Location *	WS
Category	Supplemental			GPS Latitude/Longitude	
				Start	End
Item	DWR UCIP LMA Responsibility			37.051477 °	37.051477 °
				-120.492650 °	-120.492650 °
DWR ID					
Comment Code					
Inspector Comment					
FS_ID:32789					
DS_ID:19803					
EP_NO: N/A					
Repair Type: Non-Urgent					
Crossing Status: Found					
UCIP Comments: Flapgate propped open during flood season.					
FIELD_STRUCT_DESC: 30-inch C.M. stormdrain pipe through the					
levee, 11.3 feet below the crown. Flap gate on the waterward end.					
Concrete headwall on the landward end. Concrete "U" headwall on the					
waterward end. (USACE-1967). This entry matches the Drainage or					
Irrigation Structure referenced in O&M manual (HLM 25.13).					
FS Date: 3/25/2014

Concrete headwall on LS toe.

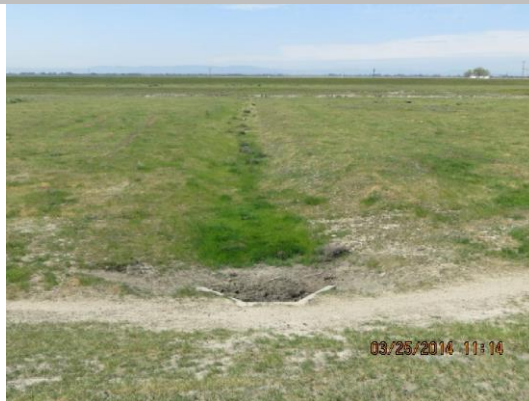
Photo 1 of 3 : UCIP_SP_2017_39625_59316.jpg

FS_ID:39625
 DS_ID:19804
 EP_NO: N/A
 Repair Type: Non-Urgent
 Crossing Status: Found
 UCIP Comments: Dense vegetation limits the inspector's visibility to identify signs of pipe failure (leaks) along the landward slope. Recommend removing vegetation along pipe alignment to conduct proper inspection of structure. Sediment buildup in pipe visible from landward side--recommend contacting owner to clear pipe.
 FIELD_STRUCT_DESC: 30-inch C.M. pipe through the levee, 12.0 feet below the crown. Flap gate on the waterward end. Concrete headwall on the landward end. Concrete "U" headwall on the waterward end. (USACE-1967). This entry matches the Drainage or Irrigation Structure referenced in O&M manual (HLM 25.51).
 FS Date: 3/25/2014

Concrete headwall on WS toe.

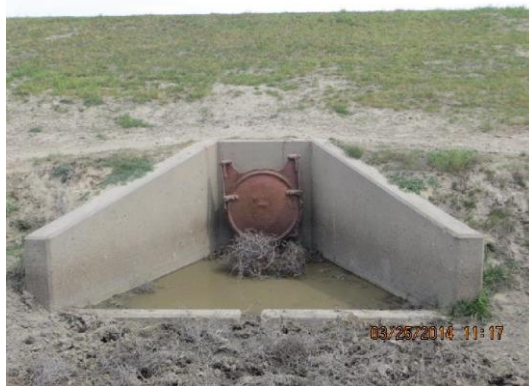
Photo 2 of 3 : UCIP_SP_2017_39625_59317.jpg

Flapgate on concrete headwall at WS toe.

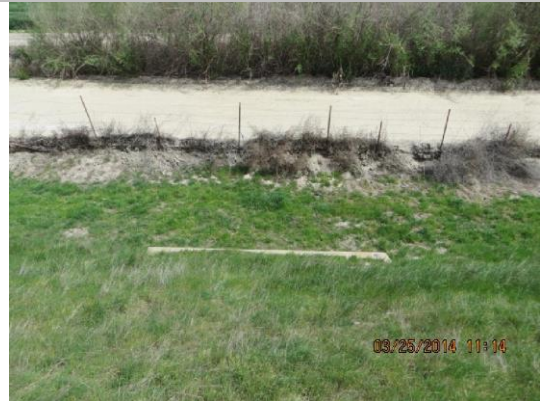
Photo 3 of 3 : UCIP_SP_2017_39625_59315.jpg

Item	DWR UCIP LMA Responsibility			37.047455 °		37.047455 °
				-120.488443 °		-120.488443 °
DWR ID						
Comment Code						
Inspector Comment						
FS_ID:39625						
DS_ID:19804						
EP_NO: N/A						
Repair Type: Non-Urgent						
Crossing Status: Found						
UCIP Comments: Dense vegetation limits the inspector's visibility to identify signs of pipe failure (leaks) along the landward slope.						
Recommend removing vegetation along pipe alignment to conduct proper inspection of structure. Sediment buildup in pipe visible from landward side--recommend contacting owner to clear pipe.						
FIELD_STRUCT_DESC: 30-inch C.M. pipe through the levee, 12.0 feet below the crown. Flap gate on the waterward end. Concrete headwall on the landward end. Concrete "U" headwall on the waterward end. (USACE-1967). This entry matches the Drainage or Irrigation Structure referenced in O&M manual (HLM 25.51).						
FS Date: 3/25/2014

Concrete headwall on LS toe.

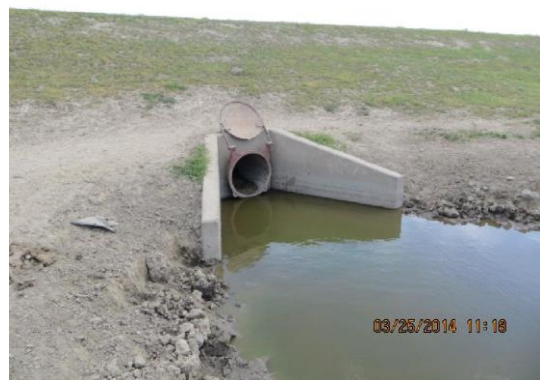
Photo 1 of 3 : UCIP_SP_2017_39626_59321.jpg

LM Start	25.63	Rating **	M	Issue No.	1382
LM End	25.63	Issue Type +	Ma	Location *	LS
Category	Supplemental			GPS Latitude/Longitude	
				Start	End
Item	DWR UCIP LMA Responsibility			37.047170 °	37.047170 °
				-120.488222 °	-120.488222 °
DWR ID					
Comment Code					
Inspector Comment					
FS_ID:39626 DS_ID:19805 EP_NO: N/A Repair Type: Non-Urgent Crossing Status: Found UCIP Comments: Sediment buildup in pipe visible from landward side--recommend contacting owner to clear pipe. FIELD_STRUCT_DESC: 30-inch C.M. stormdrain pipe through the levee, 12.1 feet below the crown. Flap gate on the waterward end. Concrete headwall on the landward end. Concrete "U" headwall on the waterward end. (USACE-1967). This entry matches the Drainage or Irrigation Structure referenced in O&M manual (HLM 25.53). FS Date: 3/25/2014

Flapgate on headwall at WS toe.

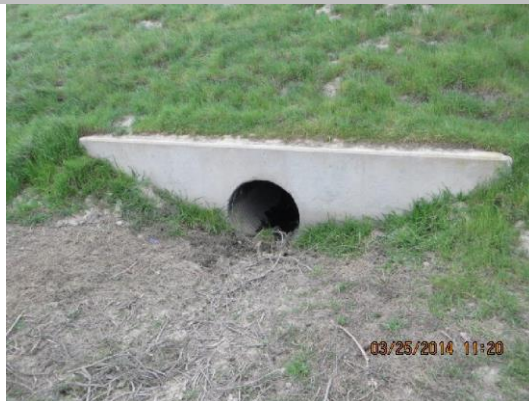
Photo 2 of 3 : UCIP_SP_2017_39626_59320.jpg

Concrete headwall on LS toe.

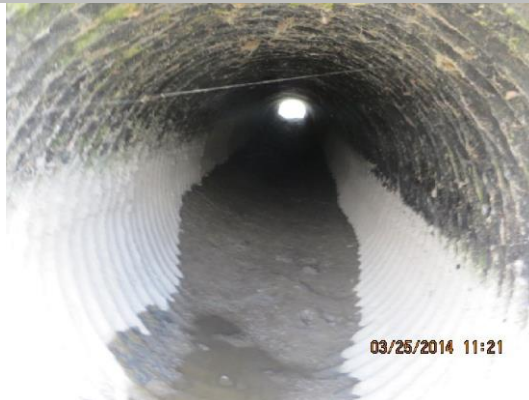
Photo 3 of 3 : UCIP_SP_2017_39626_59319.jpg

Inside pipe on LS toe.

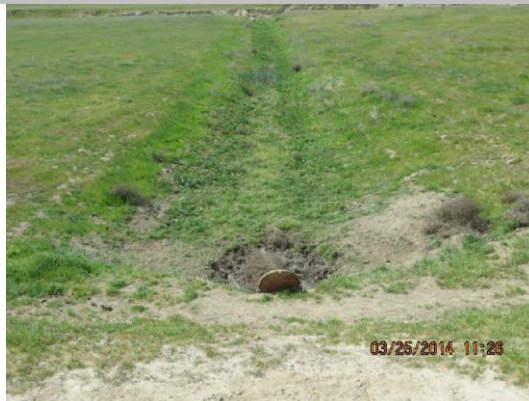
Photo 1 of 3 : UCIP_SP_2017_39627_59341.jpg

LM Start	26.20	Rating **	M	Issue No.	1383
LM End	26.20	Issue Type +	Ma	Location *	LS
Category	Supplemental			GPS Latitude/Longitude	
				Start	End
Item	DWR UCIP LMA Responsibility			37.040070 °	37.040070 °
				-120.482796 °	-120.482796 °
DWR ID					
Comment Code					
Inspector Comment					
FS_ID:39627 DS_ID:19806 EP_NO: N/A Repair Type: Non-Urgent Crossing Status: Found UCIP Comments: Sediment buildup in pipe visible from landward side--recommend contacting owner to clear pipe. FIELD_STRUCT_DESC: 24-inch C.M. stormdrain pipe through the levee, 10.0 feet below the crown. Flap gate on the waterward end. Concrete headwall on the landward end. Concrete "U" headwall on the waterward end. (USACE-1967). This entry matches the Drainage or Irrigation Structure referenced in O&M manual (HLM 26.11). FS Date: 3/25/2014

Concrete headwall on WS toe.

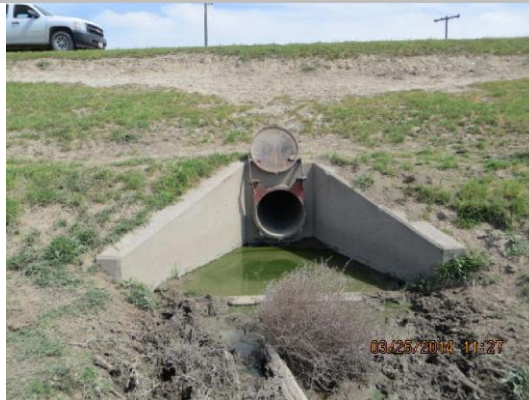
Photo 2 of 3 : UCIP_SP_2017_39627_59340.jpg

Flapgate on Concrete headwall at WS toe.

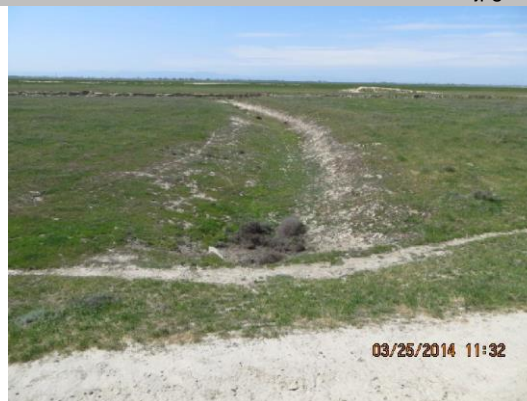
Photo 2 of 3 : UCIP_SP_2017_32804_59346.jpg

LM Start	26.39	Rating **	A/W	Issue No.	1384 (cont)
LM End	26.39	Issue Type +	Ma	Location *	LS
Category	Supplemental			GPS Latitude/Longitude	
				Start	End
Item	DWR UCIP LMA Responsibility			37.037772 °	37.037772 °
				-120.481028 °	-120.481028 °
DWR ID					
Comment Code					
Inspector Comment					
FS_ID:32804					
DS_ID:19807					
EP_NO: N/A					
Repair Type: No Action Needed					
Crossing Status: Found					
UCIP Comments:					
FIELD_STRUCT_DESC: 36-inch C.M. stormdrain pipe through the					
levee, 13.0 feet below the crown. Flap gate on the waterward end.					
Concrete headwall on the landward end. Concrete "U" headwall on the					
waterward end. (USACE-1967). This entry matches the Drainage or					
Irrigation Structure referenced in O&M manual (HLM 26.29).					
FS Date: 3/25/2014

Concrete headwall on WS toe.

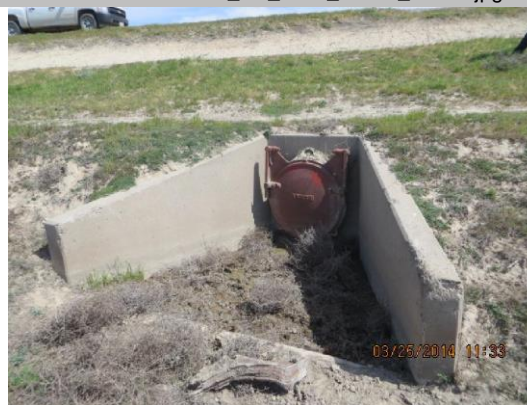
Photo 3 of 3 : UCIP_SP_2017_32804_59345.jpg

Flapgate on Concrete headwall at WS toe.

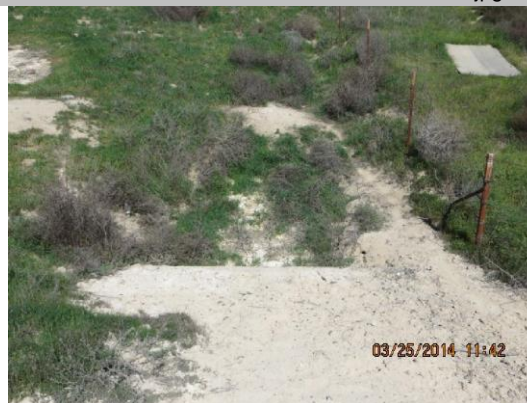
Photo 1 of 3 : UCIP_SP_2017_39628_59350.jpg

FS_ID:39628
DS_ID:19808
EP_NO: N/A
Repair Type: Non-Urgent
Crossing Status: Found
UCIP Comments: Pipe has heavy silt buildup visible from landward side--recommend contacting owner to clear pipe.
FIELD_STRUCT_DESC: 24-inch C.M. stormdrain pipe through the levee, 11.4 feet below the crown. Flap gate on the waterward end. Concrete headwall on the landward end. Concrete "U" headwall on the waterward end. (USACE-1967). This entry matches the Drainage or Irrigation Structure referenced in O&M manual (HLM 26.85).
FS Date: 3/25/2014

Concrete headwall on LS toe.

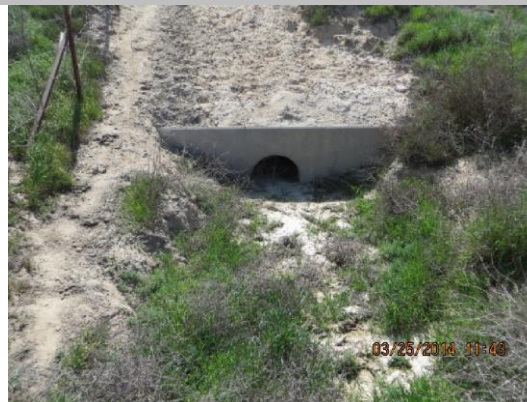
Photo 2 of 3 : UCIP_SP_2017_39628_59349.jpg

Concrete headwall on LS toe.

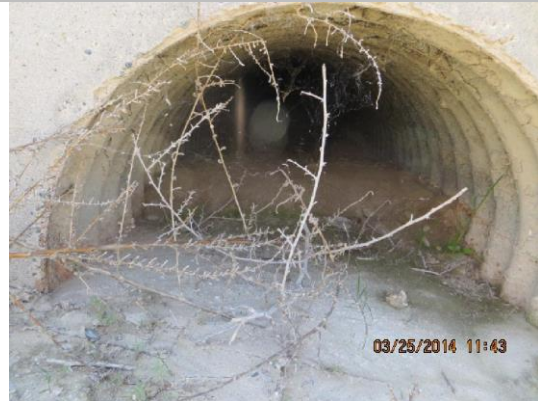
Photo 3 of 3 : UCIP_SP_2017_39628_59348.jpg

LM Start	26.95	Rating **	M	Issue No.	1385 (cont)
LM End	26.95	Issue Type +	Ma	Location *	LS
Category	Supplemental			GPS Latitude/Longitude	
				Start	End
Item	DWR UCIP LMA Responsibility			37.032669 °	37.032669 °
				-120.473901 °	-120.473901 °
DWR ID					
Comment Code					
Inspector Comment					
FS_ID:39628 DS_ID:19808 EP_NO: N/A Repair Type: Non-Urgent Crossing Status: Found UCIP Comments: Pipe has heavy silt buildup visible from landward side--recommend contacting owner to clear pipe. FIELD_STRUCT_DESC: 24-inch C.M. stormdrain pipe through the levee, 11.4 feet below the crown. Flap gate on the waterward end. Concrete headwall on the landward end. Concrete "U" headwall on the waterward end. (USACE-1967). This entry matches the Drainage or Irrigation Structure referenced in O&M manual (HLM 26.85). FS Date: 3/25/2014

Silt buildup in pipe at LS toe.

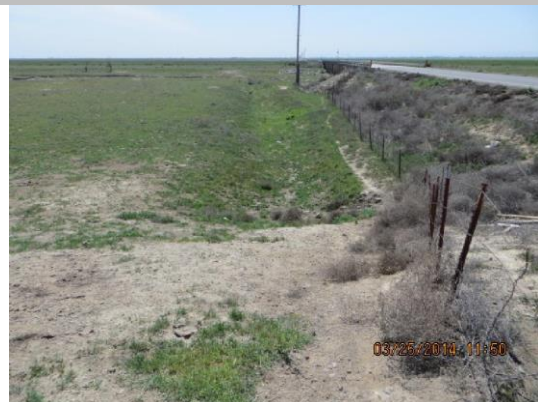
Photo 1 of 3 : UCIP_SP_2017_32806_59353.jpg

LM Start	26.97	Rating **	M	Issue No.	1386
LM End	26.97	Issue Type +	Ma	Location *	LS
Category	Supplemental			GPS Latitude/Longitude	
				Start	End
Item	DWR UCIP LMA Responsibility			37.032680 °	37.032680 °
				-120.473454 °	-120.473454 °
DWR ID					
Comment Code					
Inspector Comment					
FS_ID:32806 DS_ID:19748 EP_NO: N/A Repair Type: Non-Urgent Crossing Status: Found UCIP Comments: Tumble weed buildup at inlet mat create blockage and should be removed. FIELD_STRUCT_DESC: 24-inch C.M. stormdrain pipe through the levee, 11.3 feet below the crown. Flap gate on the waterward end. Concrete headwall on the landward end. Concrete "U" headwall on the waterward end. (USACE-1967). This entry matches the Drainage or Irrigation Structure referenced in O&M manual (HLM 26.87). FS Date: 3/25/2014

Concrete headwall at WS toe.

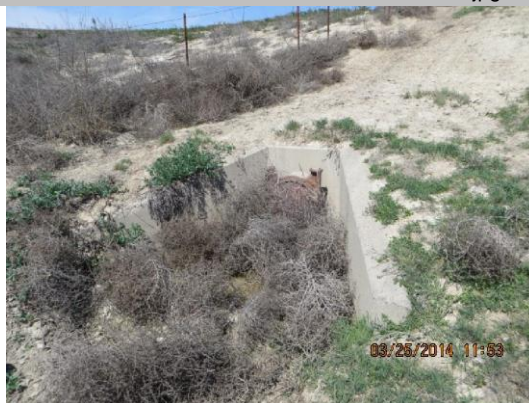
Photo 2 of 3 : UCIP_SP_2017_32806_59355.jpg

Flapgate and Concrete headwall at WS toe.

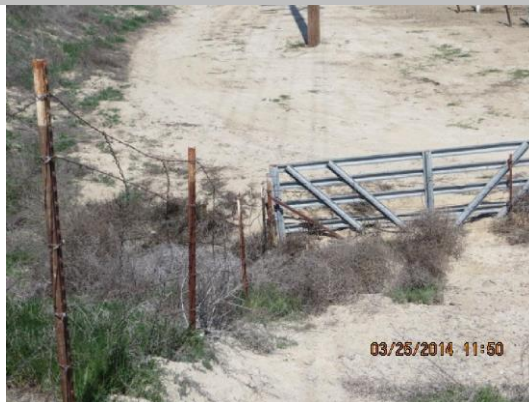
Photo 3 of 3 : UCIP_SP_2017_32806_59354.jpg

Concrete headwall at LS toe.

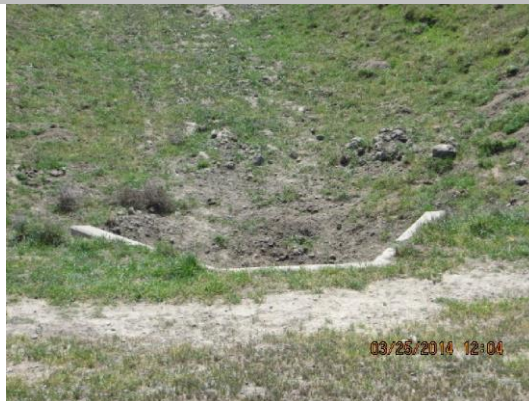
Photo 1 of 3 : UCIP_SP_2017_32807_59358.jpg

LM Start	27.31	Rating **	A/W	Issue No.	1387
LM End	27.31	Issue Type +	Ma	Location *	LS
Category	Supplemental			GPS Latitude/Longitude	
				Start	End
Item	DWR UCIP LMA Responsibility			37.032668 °	37.032668 °
				-120.467299 °	-120.467299 °
DWR ID					
Comment Code					
Inspector Comment					
FS_ID:32807					
DS_ID:19749					
EP_NO: N/A					
Repair Type: No Action Needed					
Crossing Status: Found					
UCIP Comments:					
FIELD_STRUCT_DESC: 36-inch C.M. stormdrain pipe through the					
levee, 12.0 feet below the crown. Flap gate on the waterward end.					
Concrete headwall on the landward end. Concrete "U" headwall on the					
waterward end. (USACE-1967). This entry matches the Drainage or					
Irrigation Structure referenced in O&M manual (HLM 27.22).					
FS Date: 3/25/2014

Concrete headwall on WS toe.

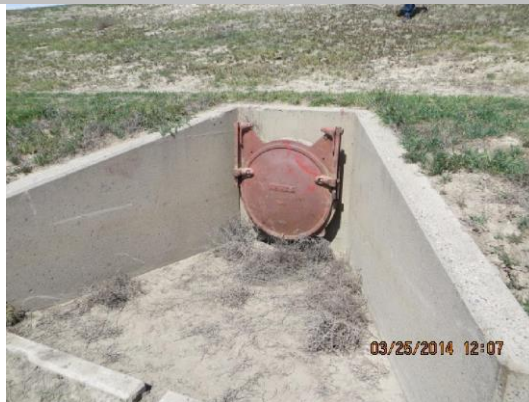
Photo 2 of 3 : UCIP_SP_2017_32807_59359.jpg

Flapgate at Concrete headwall on WS toe.

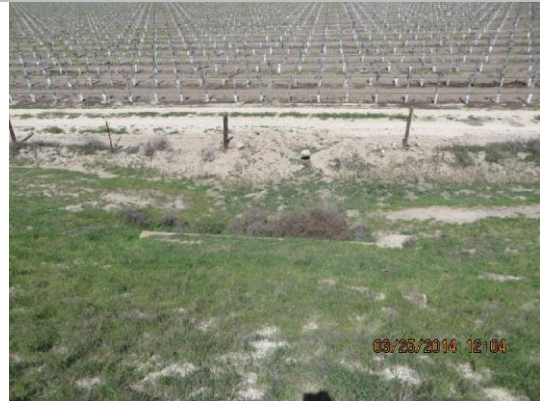
Photo 3 of 3 : UCIP_SP_2017_32807_59357.jpg

Concrete headwall on LS toe.

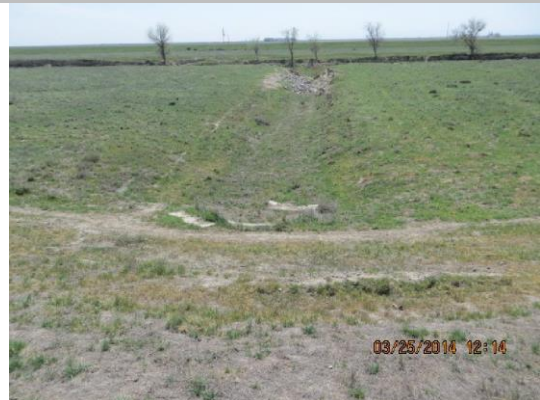
Photo 1 of 3 : UCIP_SP_2017_32823_59382.jpg

LM Start	28.27	Rating **	M	Issue No.	1388
LM End	28.27	Issue Type +	Ma	Location *	LS
Category	Supplemental			GPS Latitude/Longitude	
				Start	End
Item	DWR UCIP LMA Responsibility			37.032623 °	37.032623 °
				-120.450108 °	-120.450108 °
DWR ID					
Comment Code					
Inspector Comment					
FS_ID:32823 DS_ID:19750 EP_NO: N/A Repair Type: Non-Urgent Crossing Status: Found UCIP Comments: Animal Burrowing activity at LS toe may undermine headwall. FIELD_STRUCT_DESC: 24-inch C.M. stormdrain pipe through the levee, 10.8 feet below the crown. Flap gate on the waterward end. Concrete headwall on the landward end. Concrete "U" headwall on the waterward end. (USACE-1967). This entry matches the Drainage or Irrigation Structure referenced in O&M manual (HLM 28.17). FS Date: 3/25/2014

Concrete headwall on WS toe.

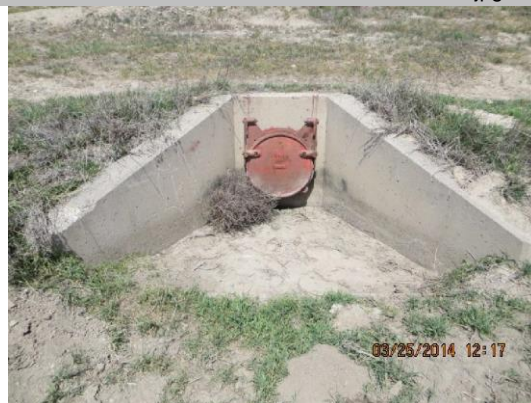
Photo 2 of 3 : UCIP_SP_2017_32823_59383.jpg

Flapgate on Concrete headwall at WS toe.

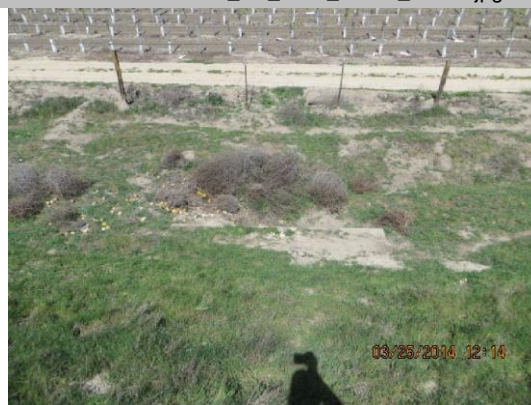
Photo 3 of 3 : UCIP_SP_2017_32823_59381.jpg

Concrete headwall on LS toe.

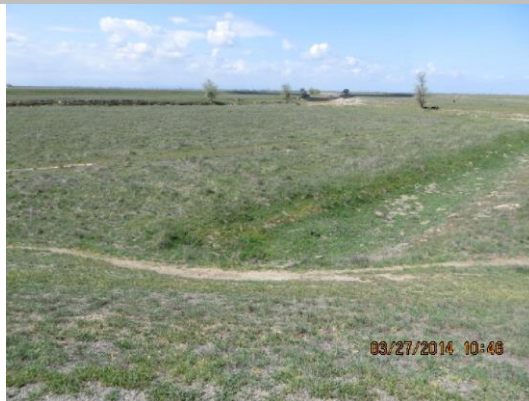
Photo 1 of 3 : UCIP_SP_2017_32832_59420.jpg

LM Start	28.79	Rating **	A/W	Issue No.	1389
LM End	28.79	Issue Type +	Ma	Location *	LS
Category	Supplemental			GPS Latitude/Longitude	
				Start	End
Item	DWR UCIP LMA Responsibility			37.031640 °	37.031640 °
				-120.441389 °	-120.441389 °
DWR ID					
Comment Code					
Inspector Comment					
FS_ID:32832					
DS_ID:19751					
EP_NO: N/A					
Repair Type: No Action Needed					
Crossing Status: Found					
UCIP Comments:					
FIELD_STRUCT_DESC: 30-inch CM stormdrain pipe through levee, 9.8					
feet below crown. Flap gate on waterward end. Concrete headwall on					
landward end. Concrete "U" headwall on the waterward end. (USACE-					
1967). This entry matches the Drainage or Irrigation Structure					
referenced in O&M manual (HLM 28.69).					
FS Date: 3/27/2014

Concrete headwall on WS toe.

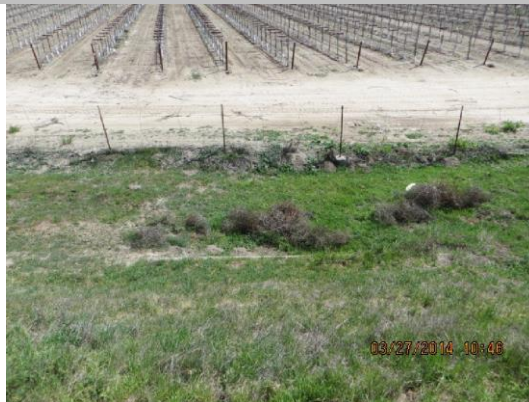
Photo 2 of 3 : UCIP_SP_2017_32832_59419.jpg

Concrete headwall on LS toe.

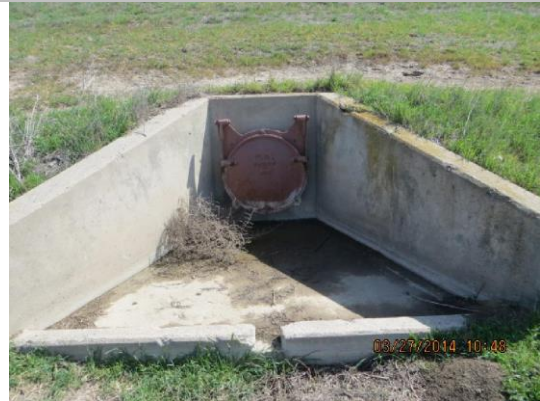
Photo 3 of 3 : UCIP_SP_2017_32832_59418.jpg

Flapgate on Concrete headwall at WS toe.

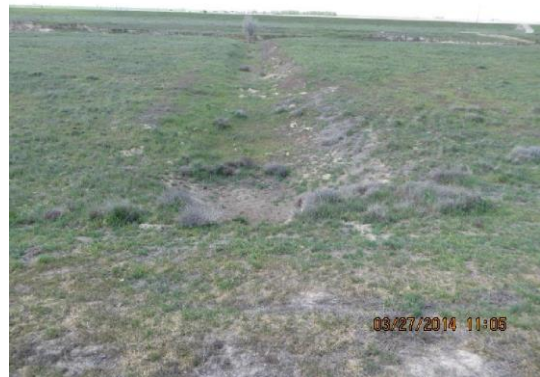
Photo 1 of 3 : UCIP_SP_2017_39884_59414.jpg

Comment Code					
Inspector Comment					
FS_ID:39884					
DS_ID:19753					
EP_NO: N/A					
Repair Type: Non-Urgent					
Crossing Status: Found					
UCIP Comments: Dense vegetation limits the inspector's visibility to identify signs of pipe failure (leaks) along the landward slope.					
Recommend removing vegetation along pipe alignment to conduct proper inspection of structure. Sediment buildup in pipe visible from landward side--recommend contacting owner to clear pipe.					
FIELD_STRUCT_DESC: 36-inch C.M. pipe through the levee, 10.2 feet below the crown. Flap gate on the waterward end. Concrete headwall on the landward end. Concrete "U" headwall on the waterward end. (USACE-1967). This entry matches the Drainage or Irrigation Structure referenced in O&M manual (HLM 29.49).					
FS Date: 3/27/2014

Concrete headwall on WS toe.

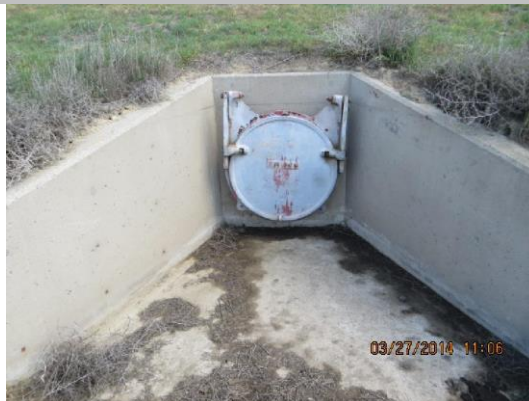
Photo 2 of 3 : UCIP_SP_2017_39884_59413.jpg

FS_ID:39884
DS_ID:19753
EP_NO: N/A
Repair Type: Non-Urgent
Crossing Status: Found
UCIP Comments: Dense vegetation limits the inspector's visibility to identify signs of pipe failure (leaks) along the landward slope. Recommend removing vegetation along pipe alignment to conduct proper inspection of structure. Sediment buildup in pipe visible from landward side--recommend contacting owner to clear pipe.
FIELD_STRUCT_DESC: 36-inch C.M. pipe through the levee, 10.2 feet below the crown. Flap gate on the waterward end. Concrete headwall on the landward end. Concrete "U" headwall on the waterward end. (USACE-1967). This entry matches the Drainage or Irrigation Structure referenced in O&M manual (HLM 29.49).
FS Date: 3/27/2014

Flapgate on Concrete headwall at WS toe.

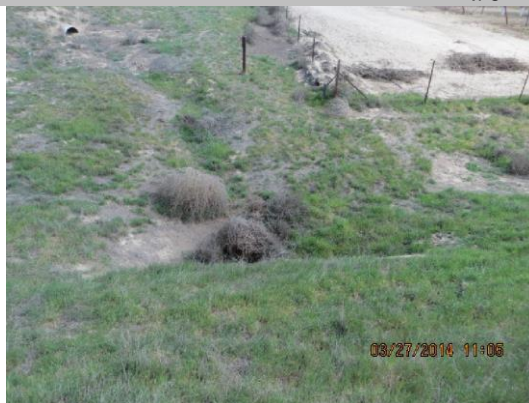
Photo 3 of 3 : UCIP_SP_2017_39884_59415.jpg

Concrete headwall on LS toe.

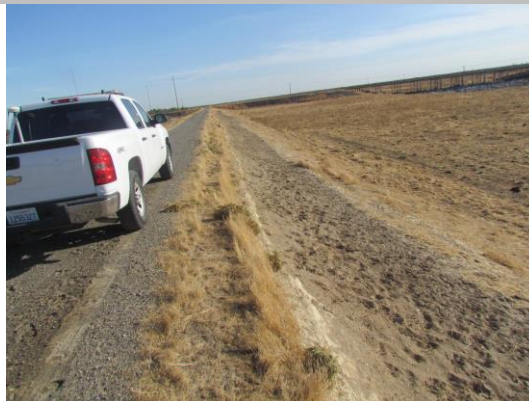
Photo 1 of 2 : SP_2017_NA0010_123_171_20170417_00011.jpg

LM Start	29.68	Rating **	M	Issue No.	171
LM End	29.80	Issue Type +	Ma	Location *	WS
Category	Earthen Levee			GPS Latitude/Longitude	
				Start	End
Item	Erosion / Bank Caving			37.020272 °	37.018712 °
				-120.433737 °	-120.432682 °
DWR ID	DWR_NA0010_05_s_2014_171				
Comment Code					
E1 : Note and monitor erosion site.					
Inspector Comment					
Waterside erosion caused by livestock.

Looking south at animal erosion on waterward slope.

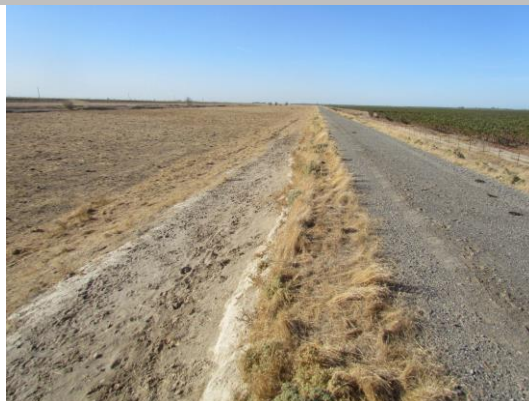
Photo 2 of 2 : SP_2017_NA0010_123_171_20170417_00012.jpg

Looking north at animal erosion on waterward slope.

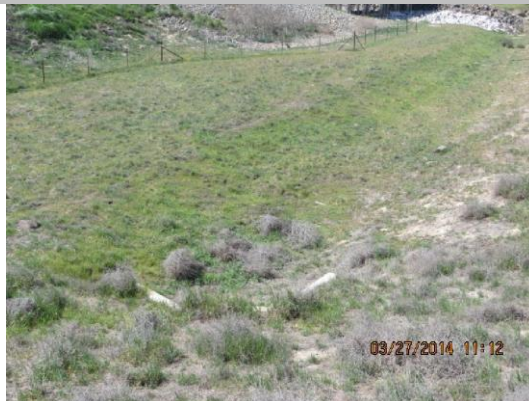
Photo 1 of 3 : UCIP_SP_2017_39631_59424.jpg

FS_ID:39631
DS_ID:19754
EP_NO: N/A
Repair Type: Non-Urgent
Crossing Status: Found
UCIP Comments: Dense vegetation limits the inspector's visibility to identify signs of pipe failure (leaks) along the landward slope. Recommend removing vegetation along pipe alignment to conduct proper inspection of structure.
FIELD_STRUCT_DESC: 30-inch square R.C.B.C. through the levee, 12.0 feet below the crown. Concrete "U" headwall on the waterward end. Flap gate on the waterward end. Concrete headwall on the landward end. (USACE-1967). This entry matches the Drainage or Irrigation Structure referenced in O&M manual (HLM 29.72).
FS Date: 3/27/2014

Concrete headwall on WS toe.

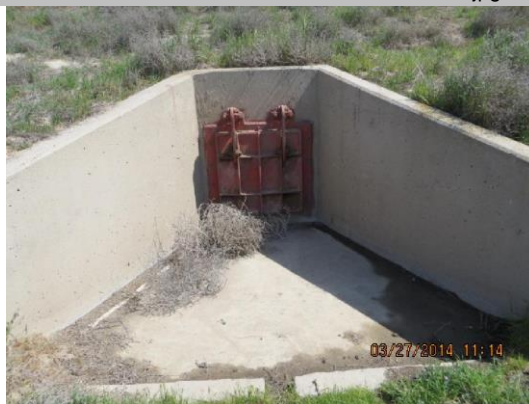
Photo 2 of 3 : UCIP_SP_2017_39631_59426.jpg

Flapgate on Concrete headwall at WS toe.

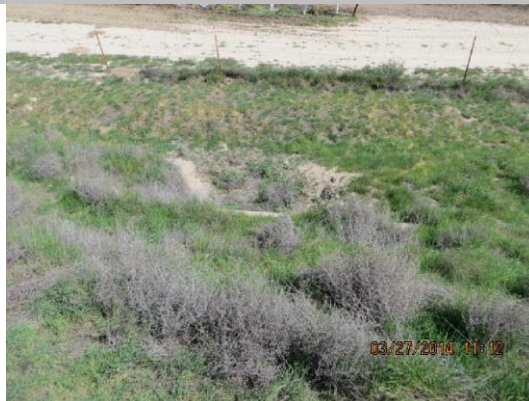
Photo 3 of 3 : UCIP_SP_2017_39631_59425.jpg

Comment Code					
Inspector Comment					
FS_ID:39631 DS_ID:19754 EP_NO: N/A Repair Type: Non-Urgent Crossing Status: Found UCIP Comments: Dense vegetation limits the inspector's visibility to identify signs of pipe failure (leaks) along the landward slope. Recommend removing vegetation along pipe alignment to conduct proper inspection of structure. FIELD_STRUCT_DESC: 30-inch square R.C.B.C. through the levee, 12.0 feet below the crown. Concrete "U" headwall on the waterward end. Flap gate on the waterward end. Concrete headwall on the landward end. (USACE-1967). This entry matches the Drainage or Irrigation Structure referenced in O&M manual (HLM 29.72). FS Date: 3/27/2014

Concrete headwall on LS toe.

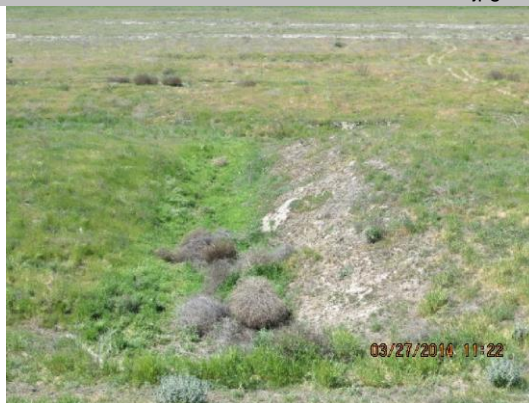
Photo 1 of 3 : UCIP_SP_2017_39632_59430.jpg

FS_ID:39632
DS_ID:19696
EP_NO: N/A
Repair Type: Non-Urgent
Crossing Status: Found
UCIP Comments: Dense vegetation limits the inspector's visibility to identify signs of pipe failure (leaks) along the landward slope. Recommend removing vegetation along pipe alignment to conduct proper inspection of structure.
FIELD_STRUCT_DESC: 30-inch square stormdrain R.C.B.C. through the levee, 13.1 feet below the crown. Concrete "U", headwall on the waterward end. Flap gate on the waterward end. Concrete headwall on the landward end. (USACE-1967). This entry matches the Drainage or Irrigation Structure referenced in O&M manual (HLM 30.04).
FS Date: 3/27/2014

Concrete headwall on WS toe.

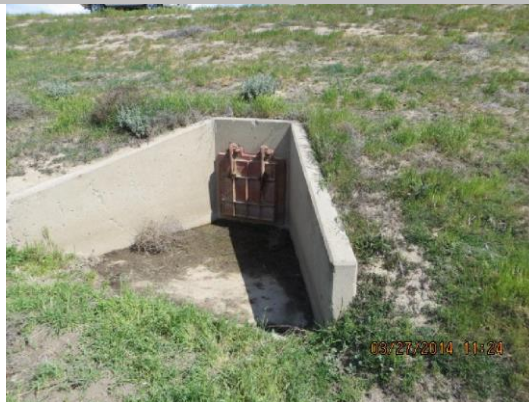
Photo 2 of 3 : UCIP_SP_2017_39632_59431.jpg

Flapgate on Concrete headwall at WS toe.

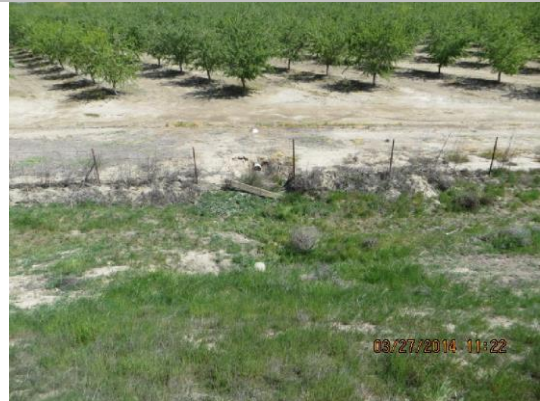
Photo 3 of 3 : UCIP_SP_2017_39632_59429.jpg

LM Start	30.14	Rating **	M	Issue No.	1393 (cont)	
LM End	30.14	Issue Type +	Ma	Location *	LS	
Category	Supplemental			GPS Latitude/Longitude		
				Start	End	
Item	DWR UCIP LMA Responsibility			37.014471 °	37.014471 °	
				-120.429759 °	-120.429759 °	
DWR ID						
Comment Code						
Inspector Comment						
FS_ID:39632						
DS_ID:19696						
EP_NO: N/A						
Repair Type: Non-Urgent						
Crossing Status: Found						
UCIP Comments: Dense vegetation limits the inspector's visibility to proper inspection of structure.						
FIELD_STRUCT_DESC: 30-inch square stormdrain R.C.B.C. through the levee, 13.1 feet below the crown. Concrete "U", headwall on the waterward end. Flap gate on the waterward end. Concrete headwall on the landward end. (USACE-1967). This entry matches the Drainage or Irrigation Structure referenced in O&M manual (HLM 30.04).						
FS Date: 3/27/2014

Concrete headwall on LS toe.

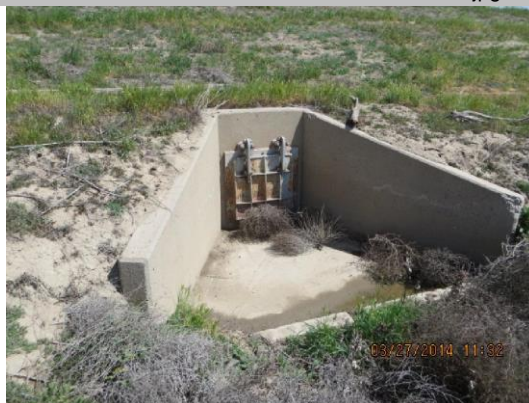
Photo 2 of 3 : UCIP_SP_2017_39633_59436.jpg

FS_ID:39633
DS_ID:19697
EP_NO: N/A
Repair Type: Non-Urgent
Crossing Status: Found
UCIP Comments: Some debris buildup at LS toe. Dense vegetation limits the inspector's visibility to identify signs of pipe failure (leaks) along the landward slope. Recommend removing vegetation along pipe alignment to conduct proper inspection of structure.
FIELD_STRUCT_DESC: 30-inch square R.C.B.C. stormdrain through the levee, 13.3 feet below the crown. Concrete "U" headwall on the waterward end. Flap gate on the waterward end. Concrete headwall on the landward end. (USACE-1967). This entry matches the Drainage or Irrigation Structure referenced in O&M manual (HLM 30.96).
FS Date: 3/27/2014

Flapgate on Concrete headwall at WS toe.

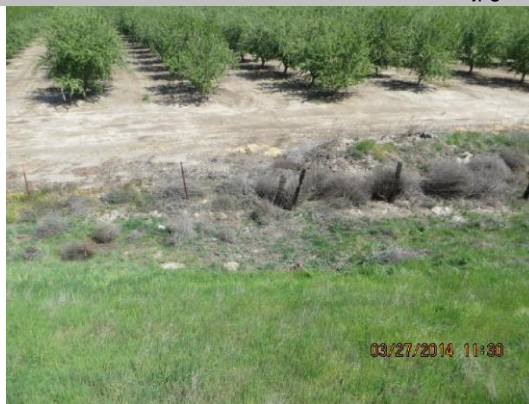
Photo 3 of 3 : UCIP_SP_2017_39633_59434.jpg

Concrete headwall on LS toe.

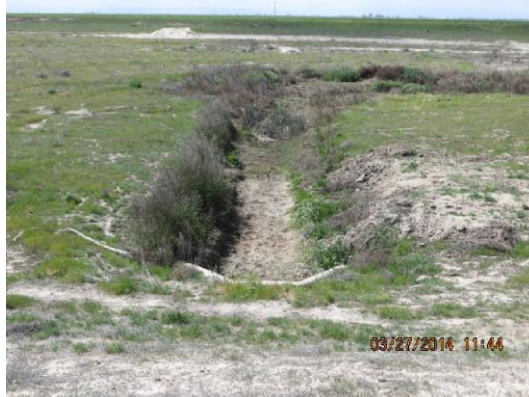
Photo 1 of 3 : UCIP_SP_2017_39643_59439.jpg

Comment Code					
Inspector Comment					
FS_ID:39643 DS_ID:19698 EP_NO: N/A Repair Type: Non-Urgent Crossing Status: Found UCIP Comments: Excess vegetation buildup at inlet on LS toe. Dense vegetation limits the inspector's visibility to identify signs of pipe failure (leaks) along the landward slope. Recommend removing vegetation along pipe alignment to conduct proper inspection of structure. FIELD_STRUCT_DESC: 30-inch square R.C.B.C. stormdrain through levee, 13.4 feet below crown. Concrete "U" headwall on waterward end. Flap gate on waterward end. Concrete headwall on landward end. (USACE-1967). This entry matches the Drainage or Irrigation Structure referenced in O&M manual (HLM 31.19). FS Date: 3/27/2014

Concrete headwall on WS toe.

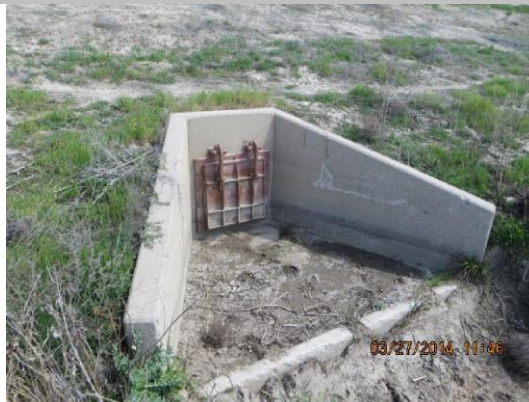
Photo 2 of 3 : UCIP_SP_2017_39643_59440.jpg

Flapgate at concrete headwall on WS toe.

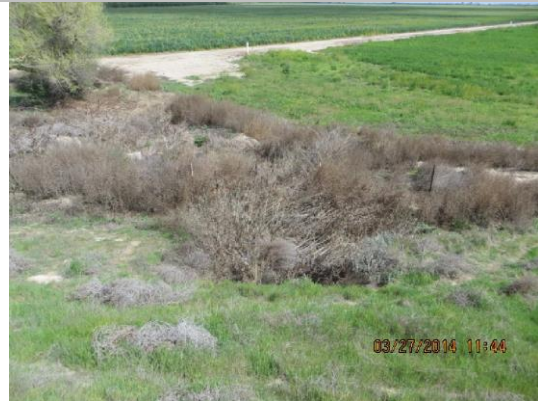
Photo 3 of 3 : UCIP_SP_2017_39643_59438.jpg

Item	DWR UCIP LMA Responsibility			37.001754 °	37.001754 °	
				-120.416254 °	-120.416254 °	
DWR ID						
Comment Code						
Inspector Comment						
FS_ID:39643 DS_ID:19698 EP_NO: N/A Repair Type: Non-Urgent Crossing Status: Found UCIP Comments: Excess vegetation buildup at inlet on LS toe. Dense vegetation limits the inspector's visibility to identify signs of pipe failure (leaks) along the landward slope. Recommend removing vegetation along pipe alignment to conduct proper inspection of structure. FIELD_STRUCT_DESC: 30-inch square R.C.B.C. stormdrain through levee, 13.4 feet below crown. Concrete "U" headwall on waterward end. Flap gate on waterward end. Concrete headwall on landward end. (USACE-1967). This entry matches the Drainage or Irrigation Structure referenced in O&M manual (HLM 31.19). FS Date: 3/27/2014

Concrete headwall on LS toe.

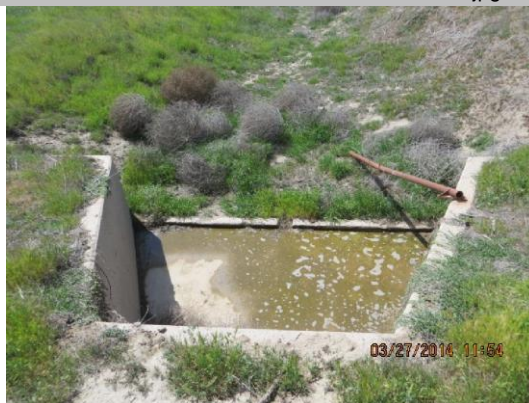
Photo 2 of 3 : UCIP_SP_2017_39644_59442.jpg

LM Start	31.74	Rating **	A/W	Issue No.	1396 (cont)	
LM End	31.74	Issue Type +	Ma	Location *	LS	
Category	Supplemental			GPS Latitude/Longitude		
				Start		End
Item	DWR UCIP LMA Responsibility			36.997001 °		36.997001 °
				-120.410991 °		-120.410991 °
DWR ID						
Comment Code						
Inspector Comment						
FS_ID:39644						
DS_ID:19699						
EP_NO: N/A						
Repair Type: No Action Needed						
Crossing Status: Found						
UCIP Comments:						
FIELD_STRUCT_DESC: 48x36-inch R.C.B.C. stormdrain through the						
levee, 14.5 feet below the crown. Concrete "U" headwall on both ends.						
Flap gate on the waterward end. (USACE-1967). This entry matches						
the Drainage or Irrigation Structure referenced in O&M manual (HLM						
31.64).						
FS Date: 3/27/2014

Concrete headwall on WS toe.

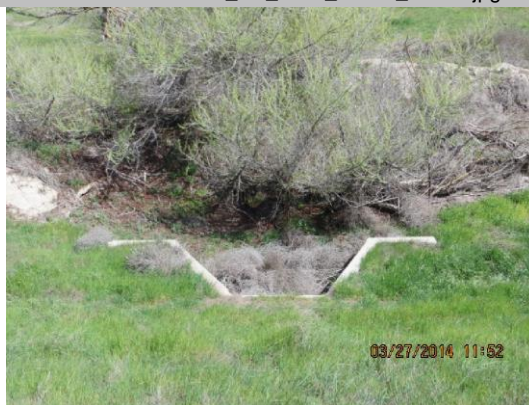
Photo 3 of 3 : UCIP_SP_2017_39644_59443.jpg

Concrete headwall on LS toe. Note tumbleweeds blocking inlet.

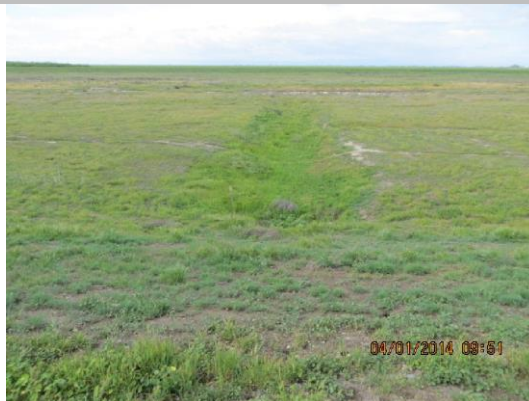
Photo 1 of 3 : UCIP_SP_2017_39645_59686.jpg

FS_ID:39645
DS_ID:19700
EP_NO: N/A
Repair Type: Non-Urgent
Crossing Status: Found
UCIP Comments: Dense vegetation limits the inspector's visibility to identify signs of pipe failure (leaks) along the landward slope. Recommend removing vegetation along pipe alignment to conduct proper inspection of structure.
FIELD_STRUCT_DESC: 30-inch square R.C.B.C. through the levee, 13.0 feet below the crown. Concrete "U" headwall on the waterward end. Flap gate on the waterward end. Concrete headwall on the landward end with flashboard attachment. (USACE-1967). This entry matches the Drainage or Irrigation Structure referenced in O&M manual (HLM 31.71).
FS Date: 4/1/2014

Concrete headwall at channel on WS toe.

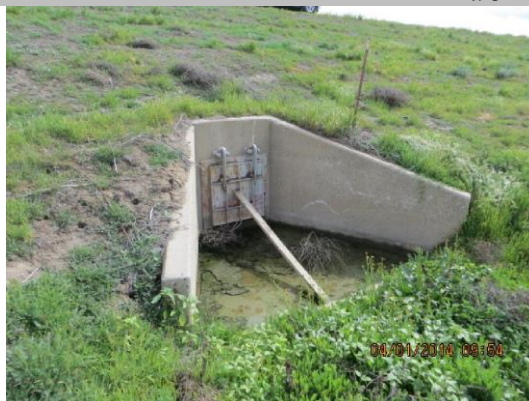
Photo 2 of 3 : UCIP_SP_2017_39645_59687.jpg

Flapgate on Concrete headwall at channel on WS toe.

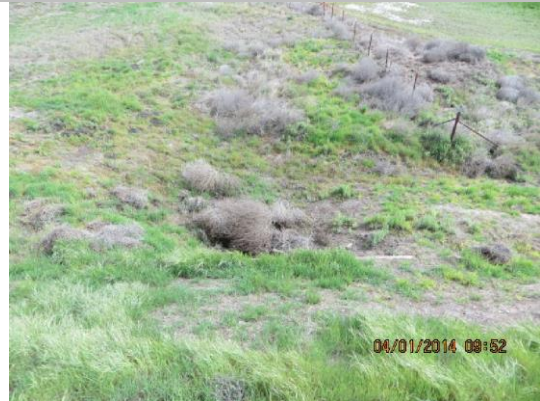
Photo 3 of 3 : UCIP_SP_2017_39645_59685.jpg

Item	DWR UCIP LMA Responsibility			36.995029 °	36.995029 °	
				-120.408914 °	-120.408914 °	
DWR ID						
Comment Code						
Inspector Comment						
FS_ID:39645						
DS_ID:19700						
EP_NO: N/A						
Repair Type: Non-Urgent						
Crossing Status: Found						
UCIP Comments: Dense vegetation limits the inspector's visibility to identify signs of pipe failure (leaks) along the landward slope.						
Recommend removing vegetation along pipe alignment to conduct proper inspection of structure.						
FIELD_STRUCT_DESC: 30-inch square R.C.B.C. through the levee, 13.0 feet below the crown. Concrete "U" headwall on the waterward end. Flap gate on the waterward end. Concrete headwall on the landward end with flashboard attachment. (USACE-1967). This entry matches the Drainage or Irrigation Structure referenced in O&M manual (HLM 31.71).						
FS Date: 4/1/2014

Concrete headwall on LS toe.

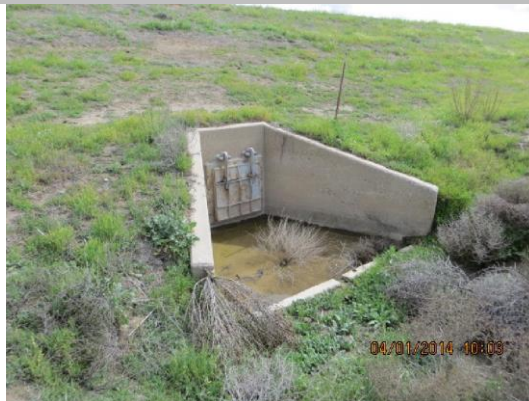
Photo 2 of 3 : UCIP_SP_2017_39646_59688.jpg

LM Start	32.32	Rating **	M	Issue No.	1398 (cont)	
LM End	32.32	Issue Type +	Ma	Location *	LS	
Category	Supplemental			GPS Latitude/Longitude		
				Start		End
Item	DWR UCIP LMA Responsibility			36.989435 °		36.989435 °
				-120.402626 °		-120.402626 °
DWR ID						
Comment Code						
Inspector Comment						
FS_ID:39646						
DS_ID:19701						
EP_NO: N/A						
Repair Type: Non-Urgent						
Crossing Status: Found						
UCIP Comments: Some silt buildup inside culvert.						
FIELD_STRUCT_DESC: 30-inch square R.C.B.C. through the levee, 14.2 feet below the crown. Concrete "U" headwall on the waterward end. Flap gate on the waterward end. Concrete headwall on the landward end with flashboard attachment. (USACE-1967). This entry matches the Drainage or Irrigation Structure referenced in O&M manual (HLM 32.22).						
FS Date: 4/1/2014

Flapgate on Concrete headwall at WS toe.

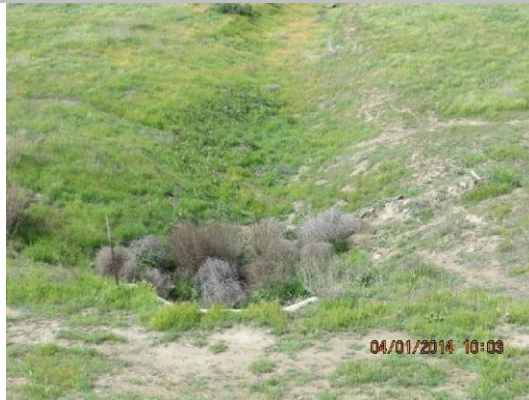
Photo 3 of 3 : UCIP_SP_2017_39646_59689.jpg

Concrete headwall at outlet on WS toe.

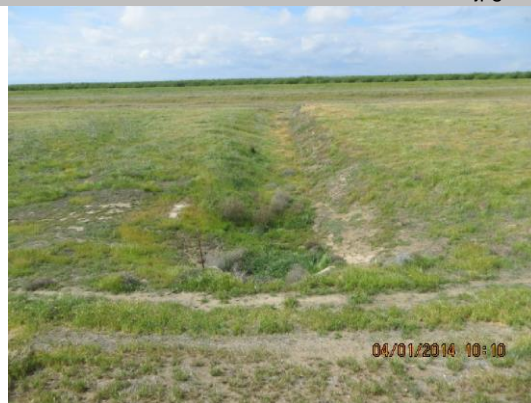
Photo 1 of 3 : UCIP_SP_2017_39647_59697.jpg

FS_ID:39647
DS_ID:19702
EP_NO: N/A
Repair Type: Non-Urgent
Crossing Status: Found
UCIP Comments: Dense vegetation limits the inspector's visibility to identify signs of pipe failure (leaks) along the landward slope. Recommend removing vegetation along pipe alignment to conduct proper inspection of structure. Debris buildup blocking landward headwall--recommend contacting owner to clear debris.
FIELD_STRUCT_DESC: 30-inch square R.C.B.C. through the levee, 12.2 feet below the crown. Concrete "U" headwall on the waterward end. Flap gate on the waterward end. Concrete headwall on the landward end. (USACE-1967). This entry matches the Drainage or Irrigation Structure referenced in O&M manual (HLM 33.01).
FS Date: 4/1/2014

Concrete headwall at WS toe.

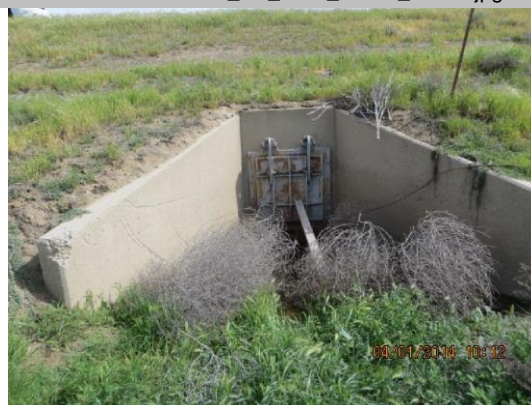
Photo 2 of 3 : UCIP_SP_2017_39647_59699.jpg

Flapgate on Concrete headwall at WS toe.

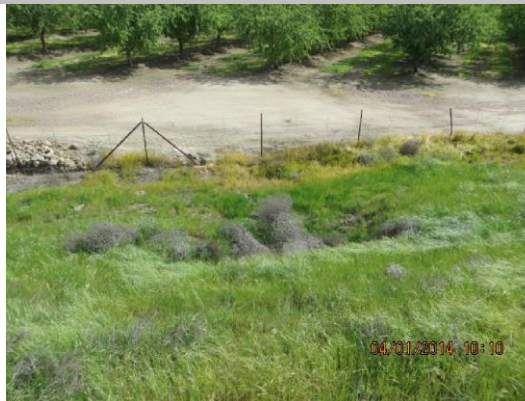
Photo 3 of 3 : UCIP_SP_2017_39647_59698.jpg

Concrete headwall at inlet on LS toe.

Comment Code					
Inspector Comment					
FS_ID:39647 DS_ID:19702 EP_NO: N/A Repair Type: Non-Urgent Crossing Status: Found UCIP Comments: Dense vegetation limits the inspector's visibility to identify signs of pipe failure (leaks) along the landward slope. Recommend removing vegetation along pipe alignment to conduct proper inspection of structure. Debris buildup blocking landward headwall--recommend contacting owner to clear debris. FIELD_STRUCT_DESC: 30-inch square R.C.B.C. through the levee, 12.2 feet below the crown. Concrete "U" headwall on the waterward end. Flap gate on the waterward end. Concrete headwall on the landward end. (USACE-1967). This entry matches the Drainage or Irrigation Structure referenced in O&M manual (HLM 33.01). FS Date: 4/1/2014
