**Flood Control Project Maintenance
Levee Inspections**

Maintenance Issue Types Only, Levee Inspection Report By Mile - Spring 2017

Lower San Joaquin Levee District

Waterway	Bank	Unit Miles	Inspection Start/End	Inspector
Unit No. 01 San Joaquin River	Right	22.52	04/17/2017 04/20/2017	Richard Willoughby

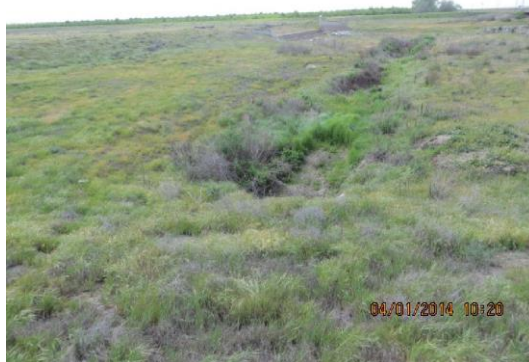
Photo 1 of 3 : UCIP_SP_2017_39648_59701.jpg

FS_ID:39648
DS_ID:19703
EP_NO: N/A
Repair Type: Non-Urgent
Crossing Status: Found
UCIP Comments: Dense vegetation limits the inspector's visibility to identify signs of pipe failure (leaks) along the slopes. Recommend removing vegetation along pipe alignment to conduct proper inspection of structure.
FIELD_STRUCT_DESC: 30-inch square R.C.B.C. through the levee, 13.9 feet below the crown. Concrete "U" headwall on the waterward end. Flap gate on the waterward end. Concrete headwall on the landward end. (USACE-1967). This entry matches the Drainage or Irrigation Structure referenced in O&M manual (HLM 33.72).
FS Date: 4/1/2014

Concrete headwall at WS toe.

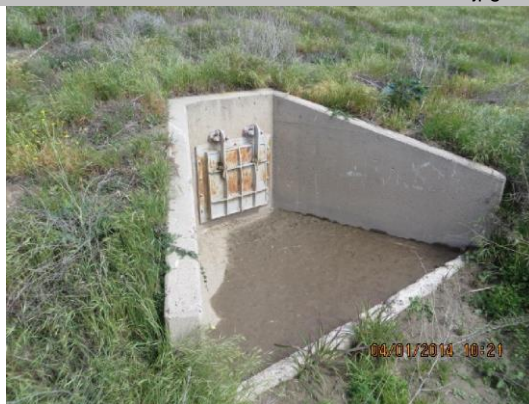
Photo 2 of 3 : UCIP_SP_2017_39648_59700.jpg

Flapgate on Concrete headwall at WS toe.

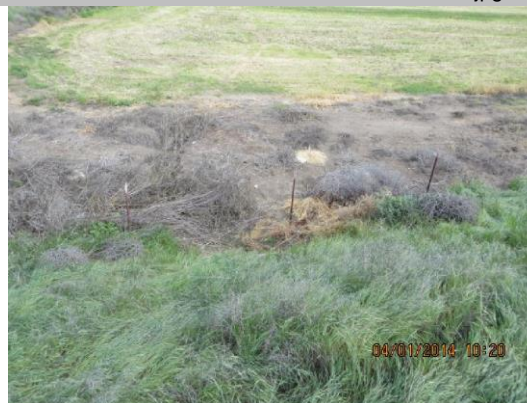
Photo 3 of 3 : UCIP_SP_2017_39648_59702.jpg

Item	DWR UCIP LMA Responsibility			36.976808 °	36.976808 °	
				-120.382593 °	-120.382593 °	
DWR ID						
Comment Code						
Inspector Comment						
FS_ID:39648						
DS_ID:19703						
EP_NO: N/A						
Repair Type: Non-Urgent						
Crossing Status: Found						
UCIP Comments: Dense vegetation limits the inspector's visibility to identify signs of pipe failure (leaks) along the slopes. Recommend removing vegetation along pipe alignment to conduct proper inspection of structure.						
FIELD_STRUCT_DESC: 30-inch square R.C.B.C. through the levee, 13.9 feet below the crown. Concrete "U" headwall on the waterward end. Flap gate on the waterward end. Concrete headwall on the landward end. (USACE-1967). This entry matches the Drainage or Irrigation Structure referenced in O&M manual (HLM 33.72).						
FS Date: 4/1/2014

Concrete headwall at LS toe.

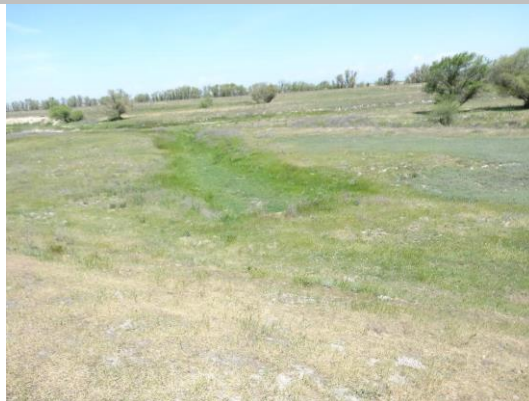
Photo 1 of 3 : UCIP_SP_2017_36565_66346.jpg

LM Start	0.78	Rating **	M	Issue No.	1214
LM End	0.78	Issue Type +	Ma	Location *	WS
Category	Supplemental			GPS Latitude/Longitude	
				Start	End
Item	DWR UCIP LMA Responsibility			37.270460 °	37.270460 °
				-120.814290 °	-120.814290 °
DWR ID					
Comment Code					
Inspector Comment					
FS_ID:36565 DS_ID:19816 EP_NO: N/A Repair Type: Non-Urgent Crossing Status: Found UCIP Comments: Landward side blocked--need to contact owner to determine status of crossing. FIELD_STRUCT_DESC: 24-inch CM pipe through levee, 16.2 feet below crown. Flap gate on the waterward end. Concrete "U" headwall on both ends. (USACE-1967). This entry matches the Drainage or Irrigation Structure referenced in O&M manual (HLM 0.86). FS Date: 4/18/2014

Overview of waterward side.

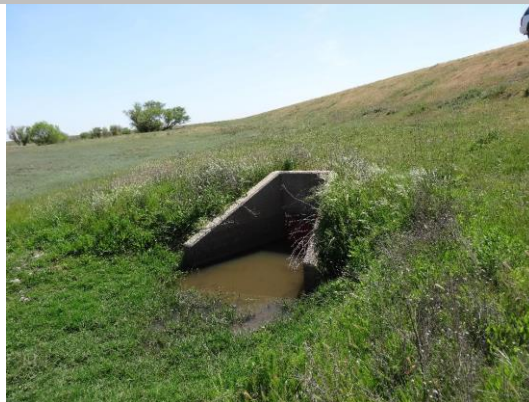
Photo 2 of 3 : UCIP_SP_2017_36565_66345.jpg

Concrete structure located on waterward toe.

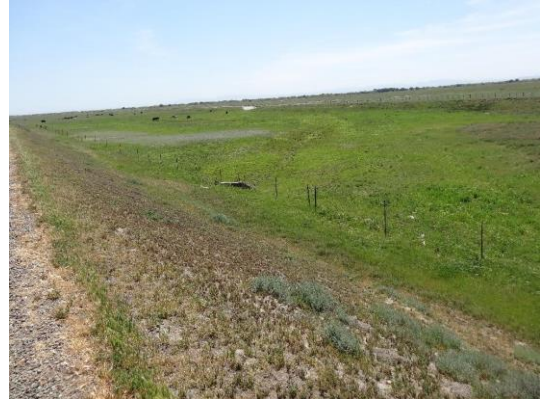
Photo 3 of 3 : UCIP_SP_2017_36565_66344.jpg

View of landward side.

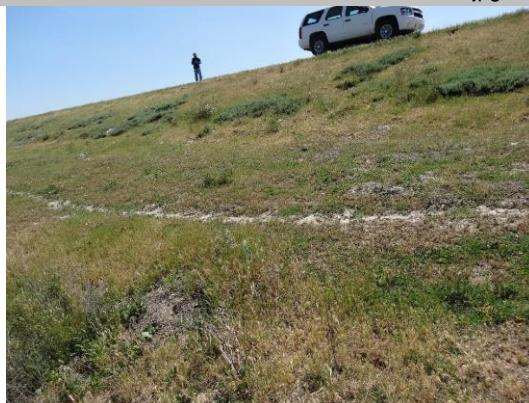
Photo 1 of 3 : UCIP_SP_2017_36566_66348.jpg

LM Start	1.87	Rating **	M	Issue No.	1215
LM End	1.87	Issue Type +	Ma	Location *	LS
Category	Supplemental			GPS Latitude/Longitude	
				Start	End
Item	DWR UCIP LMA Responsibility			37.259312 °	37.259312 °
				-120.802863 °	-120.802863 °
DWR ID					
Comment Code					
Inspector Comment					
FS_ID:36566					
DS_ID:19817					
EP_NO: N/A					
Repair Type: Non-Urgent					
Crossing Status: Found					
UCIP Comments: No access was available to landward side due to fence. Recommend removing some of the vegetation on waterward toe.					
FIELD_STRUCT_DESC: 24-inch CM pipe through levee, 13.5 feet below crown. Flap gate on the waterward end. Concrete headwall at both ends. (USACE-1967). This entry matches the Drainage or Irrigation Structure referenced in O&M manual (HLM 1.95).					
FS Date: 4/18/2014

View of waterward side.

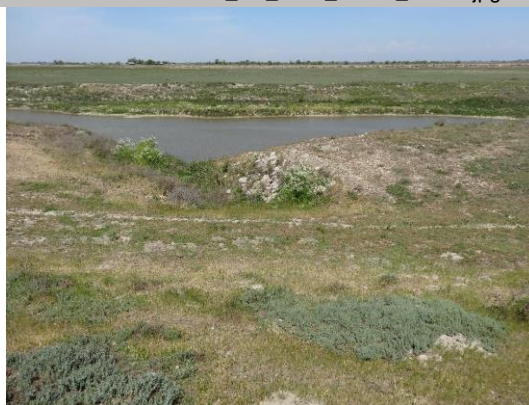
Photo 2 of 3 : UCIP_SP_2017_36566_66350.jpg

View of waterward side.

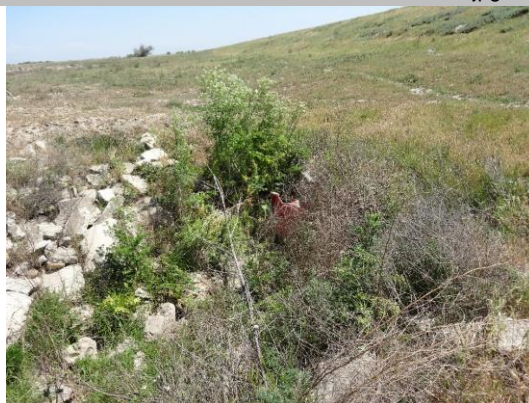
Photo 3 of 3 : UCIP_SP_2017_36566_66349.jpg

Flap gate visible on waterward side.

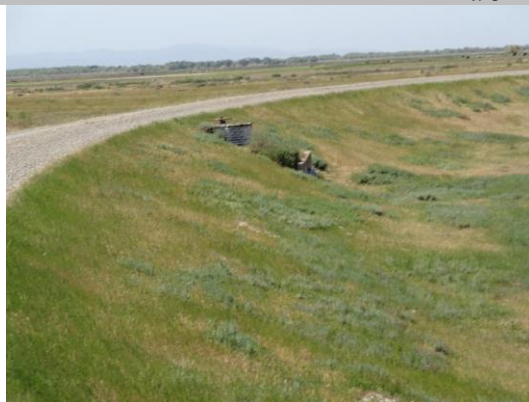
Photo 1 of 3 : UCIP_SP_2017_39464_66354.jpg

LM Start	2.53	Rating **	M	Issue No.	1216
LM End	2.53	Issue Type +	Ma	Location *	LS
Category	Supplemental			GPS Latitude/Longitude	
				Start	End
Item	DWR UCIP LMA Responsibility			37.252948 °	37.252948 °
				-120.794352 °	-120.794352 °
DWR ID					
Comment Code					
Inspector Comment					
FS_ID:39464 DS_ID:19818 EP_NO: N/A Repair Type: Non-Urgent Crossing Status: Found UCIP Comments: Need to contact owner. Sediment buildup in pipe visible on landward side. FIELD_STRUCT_DESC: 36-inch CM pipe through levee, 6.9 feet below crown. Slide gate in 48-inch CM pipe riser in the waterward slope. Concrete headwall on both ends. (USACE-1967). This entry matches the Drainage or Irrigation Structure referenced in O&M manual (HLM 2.61). FS Date: 4/18/2014

View of waterward side.

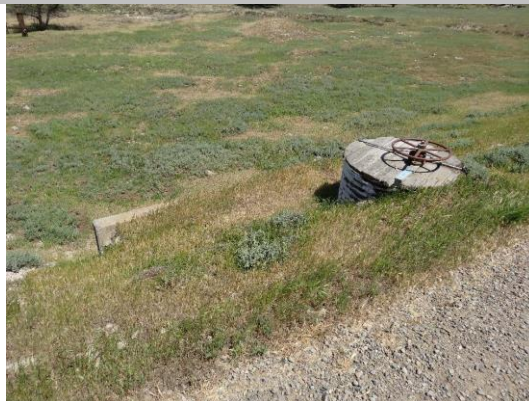
Photo 2 of 3 : UCIP_SP_2017_39464_66357.jpg

View of waterward side.

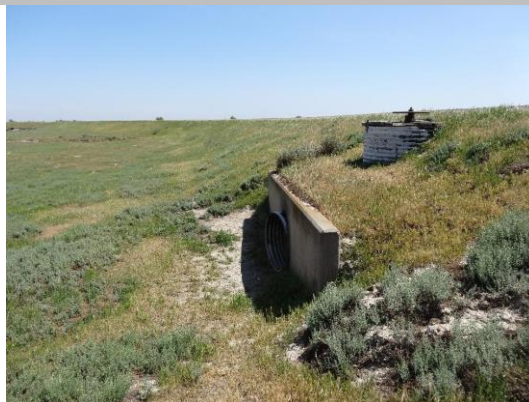
Photo 3 of 3 : UCIP_SP_2017_39464_66356.jpg

CMP riser, concrete headwall, and pipe visible on waterward side.

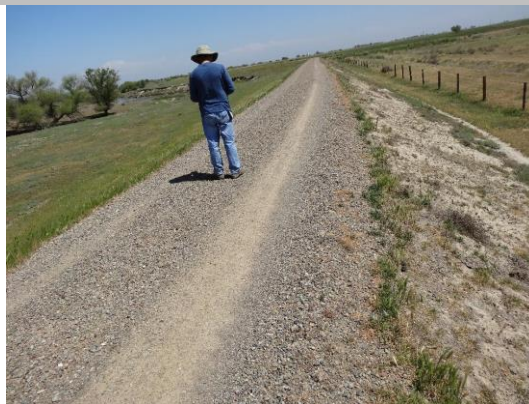
Photo 1 of 3 : UCIP_SP_2017_36568_66362.jpg

LM Start	2.57	Rating **	M	Issue No.	1217
LM End	2.57	Issue Type +	Ma	Location *	WS
Category	Supplemental			GPS Latitude/Longitude	
				Start	End
Item	DWR UCIP LMA Responsibility			37.252743 °	37.252743 °
				-120.793756 °	-120.793756 °
DWR ID					
Comment Code					
Inspector Comment					
FS_ID:36568 DS_ID:19819 EP_NO: N/A Repair Type: Non-Urgent Crossing Status: Found UCIP Comments: Dense vegetation limits the inspector's visibility to identify signs of pipe condition on landward toe--headwall blocked by dense vegetation. Recommend removing vegetation from landward toe. FIELD_STRUCT_DESC: 24-inch CM pipe through levee, 9.2 feet below crown. Flap gate on the waterward end. Concrete headwall on both ends. (USACE-1967). This entry matches the Drainage or Irrigation Structure referenced in O&M manual (HLM 2.65). FS Date: 4/18/2014

Overview of levee crown at crossing.

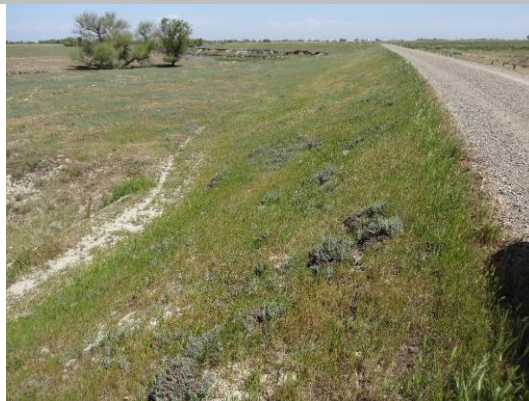
Photo 2 of 3 : UCIP_SP_2017_36568_66360.jpg

View of waterward side.

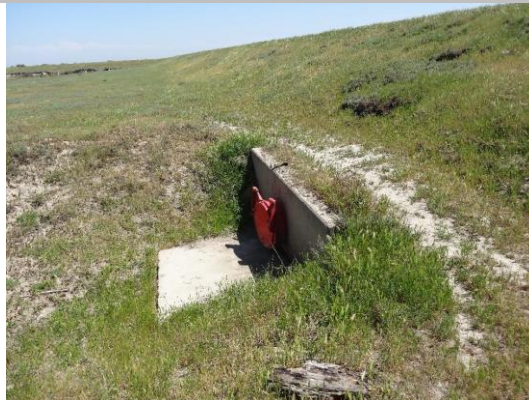
Photo 3 of 3 : UCIP_SP_2017_36568_66359.jpg

View of concrete headwall, flap gate, and concrete apron located on waterward side.

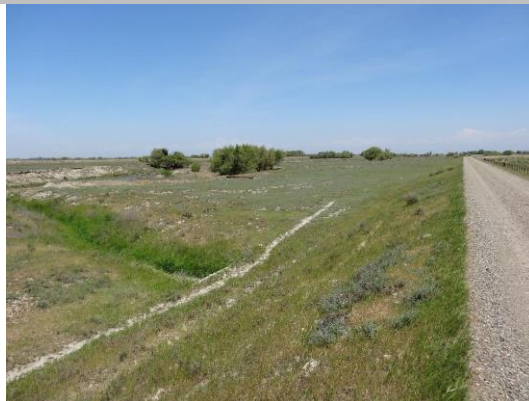
Photo 1 of 3 : UCIP_SP_2017_36569_66369.jpg

LM Start	2.77	Rating **	M	Issue No.	1218
LM End	2.77	Issue Type +	Ma	Location *	WS
Category	Supplemental			GPS Latitude/Longitude	
				Start	End
Item	DWR UCIP LMA Responsibility			37.253020 °	37.253020 °
				-120.790219 °	-120.790219 °
DWR ID					
Comment Code					
Inspector Comment					
FS_ID:36569 DS_ID:19820 EP_NO: N/A Repair Type: Non-Urgent Crossing Status: Found UCIP Comments: Dense vegetation limits the inspector's visibility to identify signs of pipe condition on landward toe--headwall blocked by dense vegetation. Recommend removing vegetation from landward toe. FIELD_STRUCT_DESC: 24-inch CM pipe through levee, 10.5 feet below crown. Flap gate on the waterward end. Concrete headwall on both ends. (USACE-1967). This entry matches the Drainage or Irrigation Structure referenced in O&M manual (HLM 2.85). FS Date: 4/18/2014

View of waterward side.

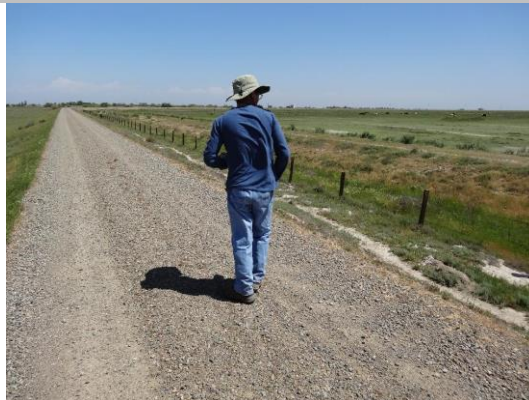
Photo 2 of 3 : UCIP_SP_2017_36569_66368.jpg

Overview of levee crown at crossing.

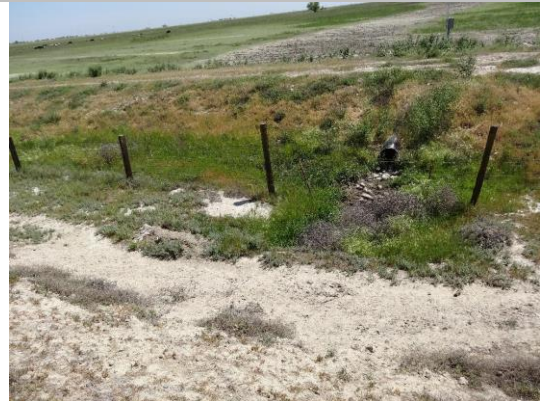
Photo 3 of 3 : UCIP_SP_2017_36569_66372.jpg

View of landward side.

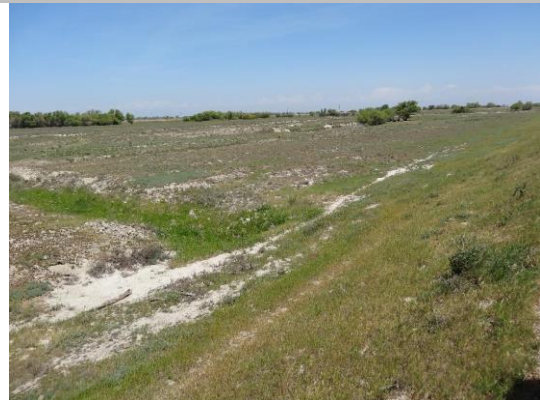
Photo 1 of 3 : UCIP_SP_2017_36583_66381.jpg

LM Start	3.01	Rating **	M	Issue No.	1219
LM End	3.01	Issue Type +	Ma	Location *	WS
Category	Supplemental			GPS Latitude/Longitude	
				Start	End
Item	DWR UCIP LMA Responsibility			37.253811 °	37.253811 °
				-120.786059 °	-120.786059 °
DWR ID					
Comment Code					
Inspector Comment					
FS_ID:36583 DS_ID:19821 EP_NO: N/A Repair Type: Non-Urgent Crossing Status: Found UCIP Comments: Dense vegetation limits the inspector's visibility to identify signs of pipe condition on landward toe--headwall blocked by dense vegetation. Recommend removing vegetation from landward toe. FIELD_STRUCT_DESC: 24 inch CM pipe through levee, 11.2 feet below crown. Flap gate on the waterward end. Concrete headwall on both ends. (USACE-1967). This entry matches the Drainage or Irrigation Structure referenced in O&M manual (HLM 3.09). FS Date: 4/18/2014

View of waterward side.

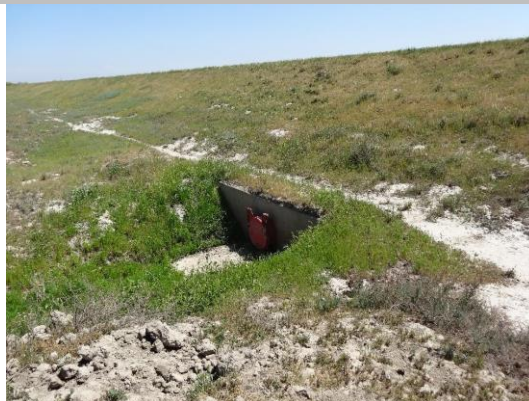
Photo 2 of 3 : UCIP_SP_2017_36583_66380.jpg

Flap gate and concrete headwall visible on waterward side.

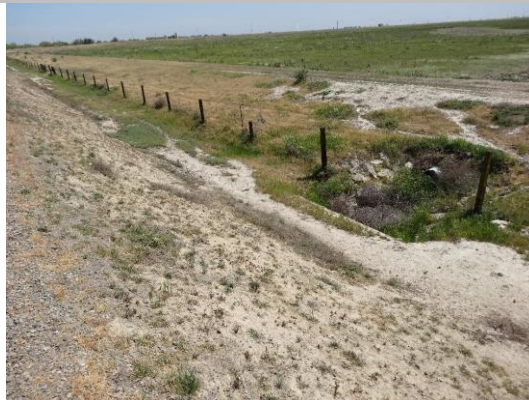
Photo 3 of 3 : UCIP_SP_2017_36583_66383.jpg

View of landward side.

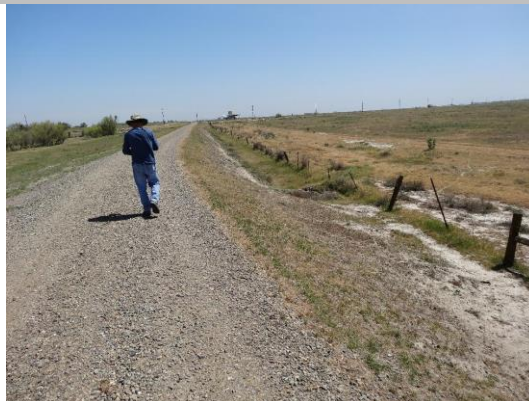
Photo 1 of 3 : UCIP_SP_2017_36584_66384.jpg

FS_ID:36584
DS_ID:19822
EP_NO: N/A
Repair Type: Non-Urgent
Crossing Status: Found
UCIP Comments: Dense vegetation limits the inspector's visibility to identify signs of pipe condition on waterward slope and landward toe (headwall blocked by dense vegetation). Recommend removing vegetation from landward toe.
FIELD_STRUCT_DESC: 24-inch CM pipe through levee, 10.4 feet below crown. Flap gate on the waterward end. Concrete headwall on both ends. (USACE-1967). This entry matches the Drainage or Irrigation Structure referenced in O&M manual (HLM 3.29).
FS Date: 4/18/2014

Overview of levee crown and landward side.

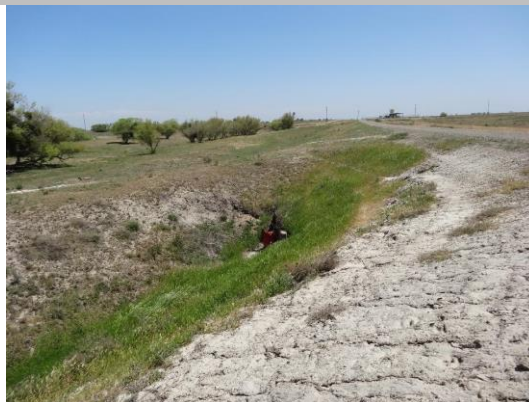
Photo 2 of 3 : UCIP_SP_2017_36584_66386.jpg

View of waterward side.

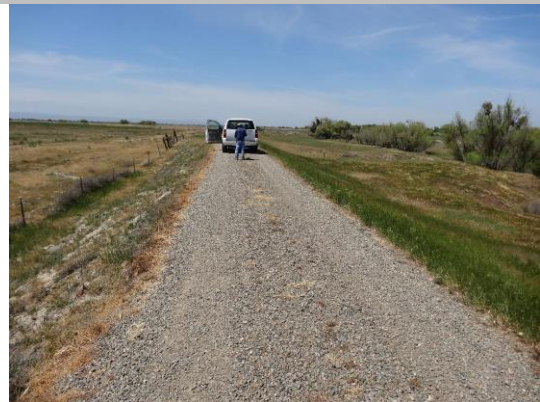
Photo 1 of 3 : UCIP_SP_2017_36585_66389.jpg

Comment Code					
Inspector Comment					
FS_ID:36585 DS_ID:19823 EP_NO: N/A Repair Type: Non-Urgent Crossing Status: Found UCIP Comments: Alignment of crossing unknown--altered crossing. No headwall found on landward side only siphon breaker found a short distance from landward toe. Tall grass observed on waterward slope and some burrow activity also noticed. Need to contact owner to determine alignment of crossing and status of crossing. FIELD_STRUCT_DESC: 36-inch CM pipe through levee, 15.7 feet below crown. Flap gate on the waterward end. Concrete "U" headwall on both ends. BM stamped 9770-152 on top of the headwall on the waterward side. (USACE-1967). This entry matches the Drainage or Irrigation Structure referenced in O&M manual (HLM 3.43). FS Date: 4/18/2014

Overview of levee crown at crossing.

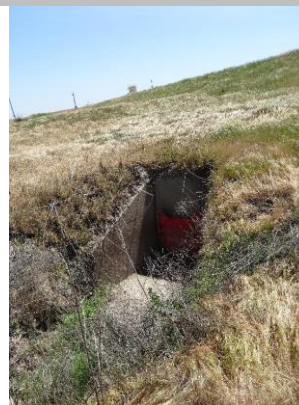
Photo 2 of 3 : UCIP_SP_2017_36585_66390.jpg

Flap gate and concrete headwall visible on waterward side.

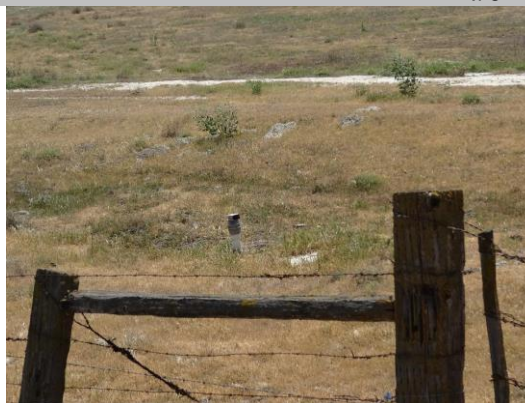
Photo 3 of 3 : UCIP_SP_2017_36585_66391.jpg

FS_ID:36585
DS_ID:19823
EP_NO: N/A
Repair Type: Non-Urgent
Crossing Status: Found
UCIP Comments: Alignment of crossing unknown--altered crossing. No headwall found on landward side only siphon breaker found a short distance from landward toe. Tall grass observed on waterward slope and some burrow activity also noticed. Need to contact owner to determine alignment of crossing and status of crossing.
FIELD_STRUCT_DESC: 36-inch CM pipe through levee, 15.7 feet below crown. Flap gate on the waterward end. Concrete "U" headwall on both ends. BM stamped 9770-152 on top of the headwall on the waterward side. (USACE-1967). This entry matches the Drainage or Irrigation Structure referenced in O&M manual (HLM 3.43).
FS Date: 4/18/2014

View of landward side. No signs of concrete headwall only siphon breaker visible on landward side.

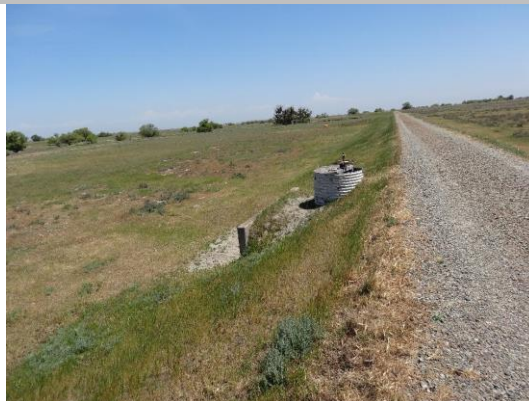
Photo 1 of 3 : UCIP_SP_2017_39465_66394.jpg

FS_ID:39465
DS_ID:19825
EP_NO: N/A
Repair Type: Non-Urgent
Crossing Status: Found
UCIP Comments: Sediment buildup inside pipe visible from landward side. Excess soil is also present on landward toe partially blocking concrete headwall and inlet. Recommend removing soil from landward toe and clear buildup inside.
FIELD_STRUCT_DESC: 36-inch CM pipe through the levee, 6.8 feet below crown. Slide gate in 48-inch CM pipe riser in the waterward slope. Concrete headwall on both ends. Pipe connects to 30-inch steel drainpipe on waterward side. Drainpipe extends to pump on waterward side, on support platform in channel. (USACE-1967). This entry matches the Drainage or Irrigation Structure referenced in O&M manual (HLM 3.54). Extension drainpipe and pump installed under Permit No. 12527 (1980).
FS Date: 4/18/2014

View of waterward side--cmp riser and concrete headwall visible.

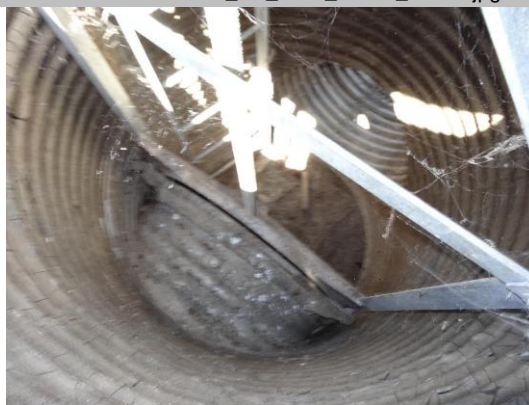
Photo 2 of 3 : UCIP_SP_2017_39465_66395.jpg

Inside view of cmp riser located on waterward slope.

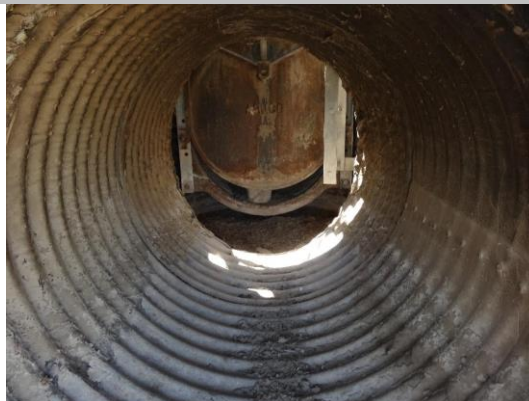
Photo 3 of 3 : UCIP_SP_2017_39465_66397.jpg

FS_ID:39465
 DS_ID:19825
 EP_NO: N/A
 Repair Type: Non-Urgent
 Crossing Status: Found
 UCIP Comments: Sediment buildup inside pipe visible from landward side. Excess soil is also present on landward toe partially blocking concrete headwall and inlet. Recommend removing soil from landward toe and clear buildup inside.
 FIELD_STRUCT_DESC: 36-inch CM pipe through the levee, 6.8 feet below crown. Slide gate in 48-inch CM pipe riser in the waterward slope. Concrete headwall on both ends. Pipe connects to 30-inch steel drainpipe on waterward side. Drainpipe extends to pump on waterward side, on support platform in channel. (USACE-1967). This entry matches the Drainage or Irrigation Structure referenced in O&M manual (HLM 3.54). Extension drainpipe and pump installed under Permit No. 12527 (1980).
 FS Date: 4/18/2014

Inside view of pipe from waterward side.

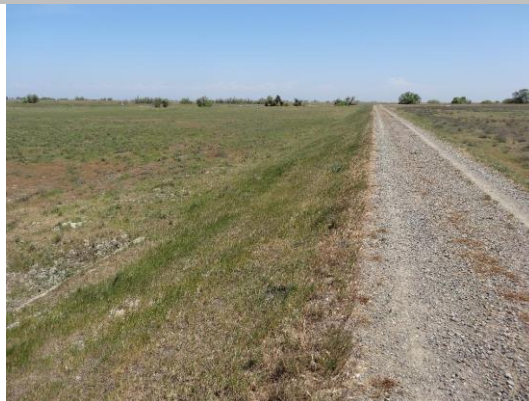
Photo 1 of 3 : UCIP_SP_2017_39466_66413.jpg

LM Start	3.69	Rating **	M	Issue No.	1224
LM End	3.69	Issue Type +	Ma	Location *	WS
Category	Supplemental			GPS Latitude/Longitude	
				Start	End
Item	DWR UCIP LMA Responsibility			37.251199 °	37.251199 °
				-120.774474 °	-120.774474 °
DWR ID					
Comment Code					
Inspector Comment					
FS_ID:39466 DS_ID:19826 EP_NO: N/A Repair Type: Non-Urgent Crossing Status: Found UCIP Comments: Sediment buildup inside crossing and is visible from landward side. Recommend clearing sediment buildup inside pipe and check wall integrity to determine condition. FIELD_STRUCT_DESC: 24-inch CM pipe through levee, 7.0 feet below crown. Flap gate on the waterward end. Concrete headwall on both ends. (USACE-1967). This entry matches the Drainage or Irrigation Structure referenced in O&M manual (HLM 3.77). FS Date: 4/18/2014

View of waterward side.

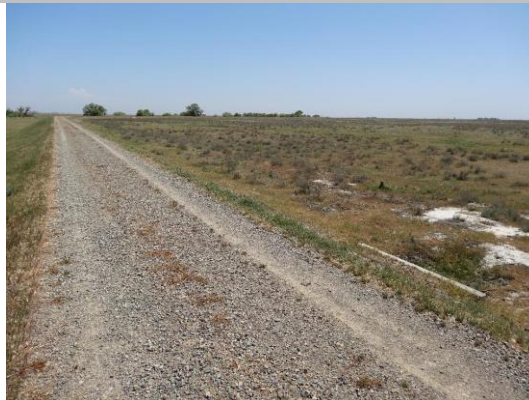
Photo 2 of 3 : UCIP_SP_2017_39466_66412.jpg

View of landward side.

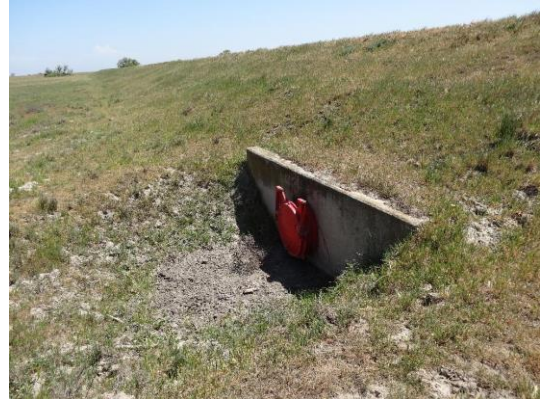
Photo 3 of 3 : UCIP_SP_2017_39466_66411.jpg

View of flap gate visible on waterward side.

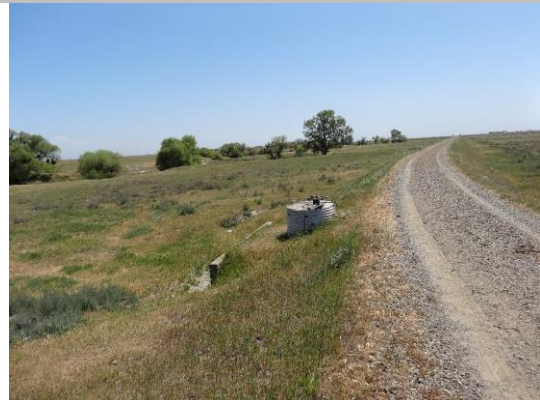
Photo 1 of 3 : UCIP_SP_2017_39467_66407.jpg

LM Start	3.89	Rating **	M	Issue No.	1225
LM End	3.89	Issue Type +	Ma	Location *	WS
Category	Supplemental			GPS Latitude/Longitude	
				Start	End
Item	DWR UCIP LMA Responsibility			37.250742 °	37.250742 °
				-120.771026 °	-120.771026 °
DWR ID					
Comment Code					
Inspector Comment					
FS_ID:39467 DS_ID:19827 EP_NO: N/A Repair Type: Non-Urgent Crossing Status: Found UCIP Comments: Sediment buildup inside crossing and is visible from landward side. Recommend clearing sediment buildup inside pipe and check wall integrity to determine condition. FIELD_STRUCT_DESC: 36-inch CM pipe through levee, 6.7 feet below crown. Slide gate in 48-inch CM pipe riser in the waterward slope. (USACE-1967). This entry matches the Drainage or Irrigation Structure referenced in O&M manual (HLM 3.97). FS Date: 4/18/2014

View of waterward side.

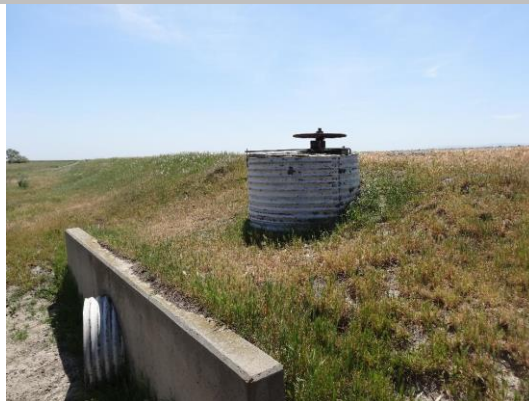
Photo 2 of 3 : UCIP_SP_2017_39467_66406.jpg

Slide gate inside CMP riser visible on waterward slope.

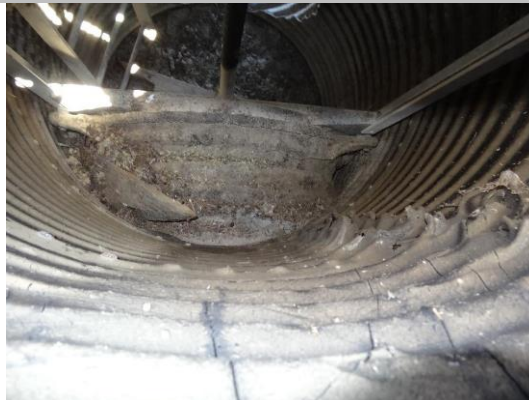
Photo 3 of 3 : UCIP_SP_2017_39467_66410.jpg

Inside view of CMP riser located on waterward side.

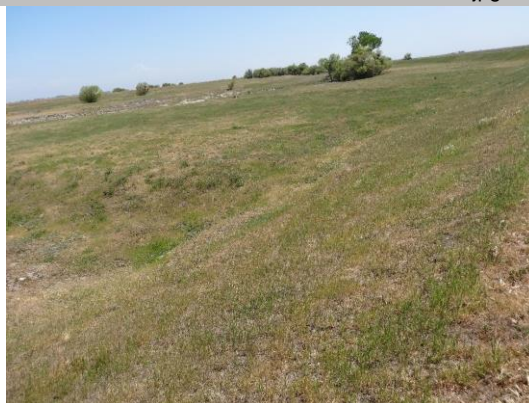
Photo 1 of 3 : UCIP_SP_2017_36606_66418.jpg

LM Start	4.09	Rating **	M	Issue No.	1226
LM End	4.09	Issue Type +	Ma	Location *	WS
Category	Supplemental			GPS Latitude/Longitude	
				Start	End
Item	DWR UCIP LMA Responsibility			37.248353 °	37.248353 °
				-120.768922 °	-120.768922 °
DWR ID					
Comment Code					
Inspector Comment					
FS_ID:36606 DS_ID:19828 EP_NO: N/A Repair Type: Non-Urgent Crossing Status: Found UCIP Comments: Dense vegetation limits the inspector's visibility to identify signs of pipe condition on landward toe--headwall blocked by dense vegetation. Recommend removing vegetation from landward toe. FIELD_STRUCT_DESC: 24-inch CM pipe through levee, 10.8 feet below crown. Flap gate on the waterward end. Concrete headwall on both ends. (USACE-1967). This entry matches the Drainage or Irrigation Structure referenced in O&M manual (HLM 4.17). FS Date: 4/18/2014

View of waterward side.

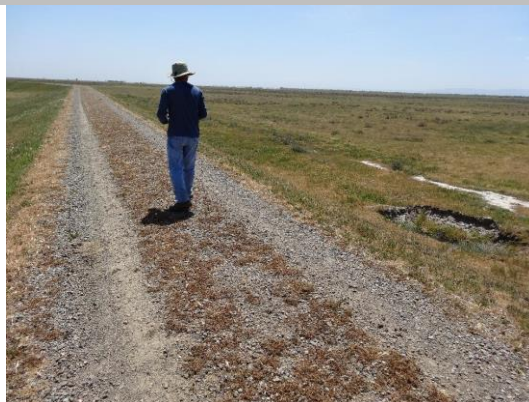
Photo 2 of 3 : UCIP_SP_2017_36606_66417.jpg

Overview of levee crown at crossing.

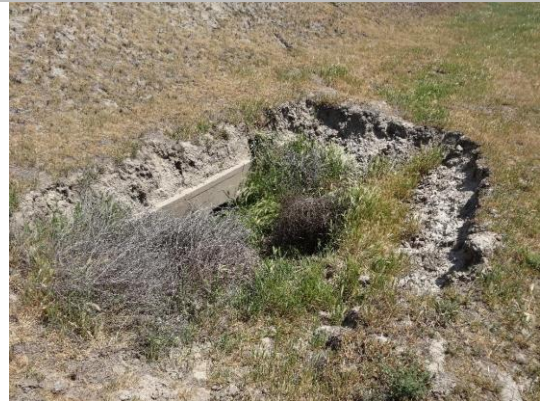
Photo 3 of 3 : UCIP_SP_2017_36606_66416.jpg

Item	DWR UCIP LMA Responsibility			37.248353 °	37.248353 °	
				-120.768922 °	-120.768922 °	
DWR ID						
Comment Code						
Inspector Comment						
FS_ID:36606						
DS_ID:19828						
EP_NO: N/A						
Repair Type: Non-Urgent						
Crossing Status: Found						
UCIP Comments: Dense vegetation limits the inspector's visibility to identify signs of pipe condition on landward toe--headwall blocked by dense vegetation. Recommend removing vegetation from landward toe.						
FIELD_STRUCT_DESC: 24-inch CM pipe through levee, 10.8 feet below crown. Flap gate on the waterward end. Concrete headwall on both ends. (USACE-1967). This entry matches the Drainage or Irrigation Structure referenced in O&M manual (HLM 4.17).						
FS Date: 4/18/2014

Concrete headwall visible on landward side.

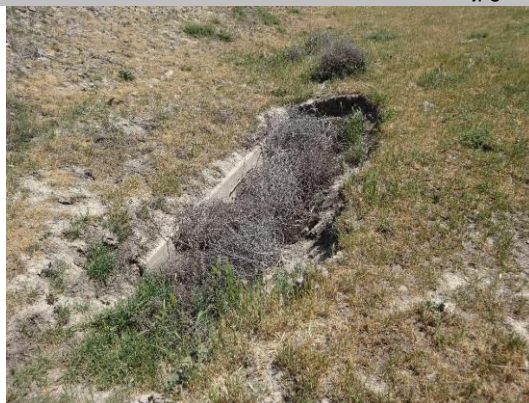
Photo 2 of 2 : UCIP_SP_2017_36607_66421.jpg

LM Start	4.33	Rating **	M	Issue No.	1227 (cont)
LM End	4.33	Issue Type +	Ma	Location *	WS
Category	Supplemental			GPS Latitude/Longitude	
				Start	End
Item	DWR UCIP LMA Responsibility			37.246459 °	37.246459 °
				-120.765470 °	-120.765470 °
DWR ID					
Comment Code					
Inspector Comment					
FS_ID:36607 DS_ID:19829 EP_NO: N/A Repair Type: Non-Urgent Crossing Status: Found UCIP Comments: Dense vegetation limits the inspector's visibility to identify signs of pipe condition on landward toe--headwall blocked by dense vegetation. Recommend removing vegetation from landward toe. FIELD_STRUCT_DESC: 24-inch CM pipe through levee, 11.3 feet below crown. Flap gate on the waterward end. Concrete headwall on both ends. (USACE-1967). This entry matches the Drainage or Irrigation Structure referenced in O&M manual (HLM 4.41). FS Date: 4/18/2014

View of landward side--concrete headwall visible through dense vegetation.

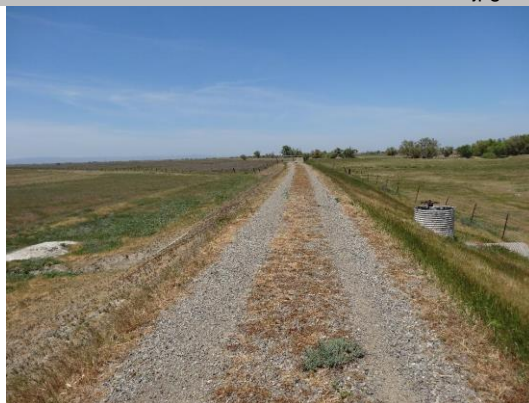
Photo 1 of 3 : UCIP_SP_2017_39468_66425.jpg

FS_ID:39468
DS_ID:19830
EP_NO: N/A
Repair Type: Non-Urgent
Crossing Status: Found
UCIP Comments: Sediment buildup inside crossing visible from landward side. Recommend clearing sediment buildup inside pipe and check wall integrity to determine condition.
FIELD_STRUCT_DESC: 36-inch CM pipe through levee, 6.9 feet below crown. Slide gate in 48-inch CM pipe riser in the waterward slope. Concrete headwall on the landward end. Concrete saddle and apron on the waterward end. (USACE-1967). This entry matches the Drainage or Irrigation Structure referenced in O&M manual (HLM 4.70).
FS Date: 4/18/2014

Overview of levee crown at crossing.

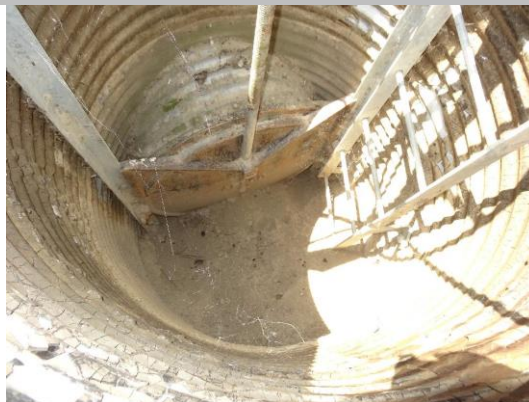
Photo 2 of 3 : UCIP_SP_2017_39468_66426.jpg

Inside view of CMP riser located on waterward.

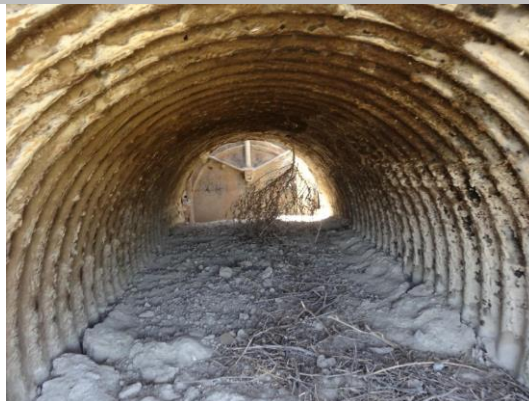
Photo 3 of 3 : UCIP_SP_2017_39468_66424.jpg

LM Start	4.62	Rating **	M	Issue No.	1228 (cont)
LM End	4.62	Issue Type +	Ma	Location *	CR
Category	Supplemental			GPS Latitude/Longitude	
				Start	End
Item	DWR UCIP LMA Responsibility			37.243946 °	37.243946 °
				-120.761296 °	-120.761296 °
DWR ID					
Comment Code					
Inspector Comment					
FS_ID:39468 DS_ID:19830 EP_NO: N/A Repair Type: Non-Urgent Crossing Status: Found UCIP Comments: Sediment buildup inside crossing visible from landward side. Recommend clearing sediment buildup inside pipe and check wall integrity to determine condition. FIELD_STRUCT_DESC: 36-inch CM pipe through levee, 6.9 feet below crown. Slide gate in 48-inch CM pipe riser in the waterward slope. Concrete headwall on the landward end. Concrete saddle and apron on the waterward end. (USACE-1967). This entry matches the Drainage or Irrigation Structure referenced in O&M manual (HLM 4.70). FS Date: 4/18/2014

Inside view of pipe from waterward side.

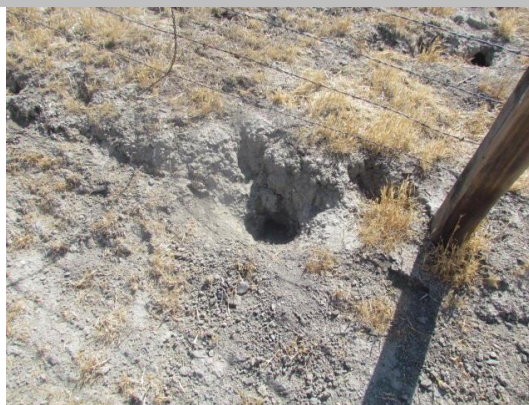
Photo 1 of 2 : SP_2017_NA0010_124_10_20170417_00010.jpg

LM Start	4.66	Rating **	M	Issue No.	10
LM End	4.66	Issue Type +	Ma	Location *	LS
Category	Earthen Levee			GPS Latitude/Longitude	
				Start	End
Item	Animal Control			37.243540 °	37.243540 °
				-120.760782 °	-120.760782 °
DWR ID	DWR_NA0010_06_s_2012_10				
Comment Code					
A3 : No rodents visible, but rodent burrows visible; need to backfill and compact or grout burrows.					
Inspector Comment					
Rodent holes next to fence post on landward slope.

Looking at rodent hole along fence line on landward slope.

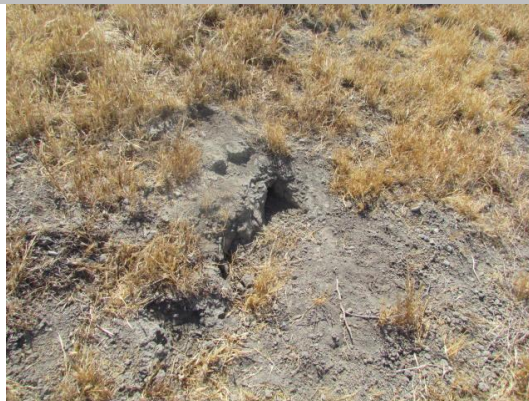
Photo 2 of 2 : SP_2017_NA0010_124_10_20170417_00011.jpg

LM Start	4.66	Rating **	M	Issue No.	10 (cont)	
LM End	4.66	Issue Type +	Ma	Location *	LS	
Category	Earthen Levee			GPS Latitude/Longitude		
				Start		End
Item	Animal Control			37.243540 °		37.243540 °
				-120.760782 °		-120.760782 °
DWR ID	DWR_NA0010_06_s_2012_10					
Comment Code						
A3 : No rodents visible, but rodent burrows visible; need to backfill and compact or grout burrows.						
Inspector Comment						
Rodent holes next to fence post on landward slope.

Looking at typical rodent holes on landward slope.

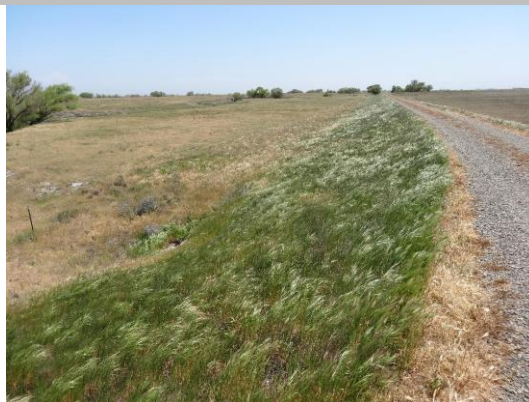
Photo 1 of 3 : UCIP_SP_2017_36609_66433.jpg

LM Start	4.67	Rating **	M	Issue No.	1229
LM End	4.67	Issue Type +	Ma	Location *	LS
Category	Supplemental			GPS Latitude/Longitude	
				Start	End
Item	DWR UCIP LMA Responsibility			37.243408 °	37.243408 °
				-120.760564 °	-120.760564 °
DWR ID					
Comment Code					
Inspector Comment					
FS_ID:36609 DS_ID:19831 EP_NO: N/A Repair Type: Non-Urgent Crossing Status: Found UCIP Comments: Need to contact owner. Recommend removing tall grass on landward toe to determine condition of crossing from landward side. FIELD_STRUCT_DESC: 24-inch CM pipe through levee, 11.8 feet below crown. Flap gate on the waterward end. Concrete headwall on both ends. (USACE-1967). This entry matches the Drainage or Irrigation Structure referenced in O&M manual (HLM 4.75). FS Date: 4/18/2014

View of waterward side.

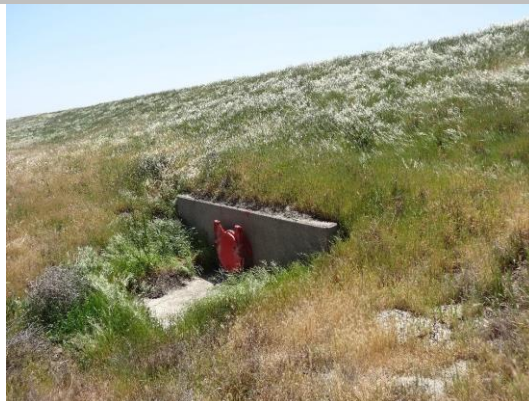
Photo 2 of 3 : UCIP_SP_2017_36609_66432.jpg

Flap gate, concrete headwall and apron visible on waterward toe.

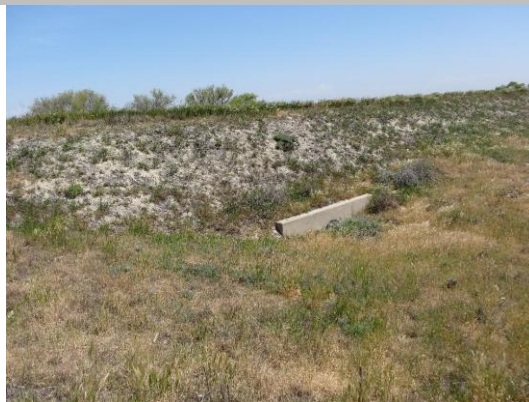
Photo 3 of 3 : UCIP_SP_2017_36609_66431.jpg

View of landward side.

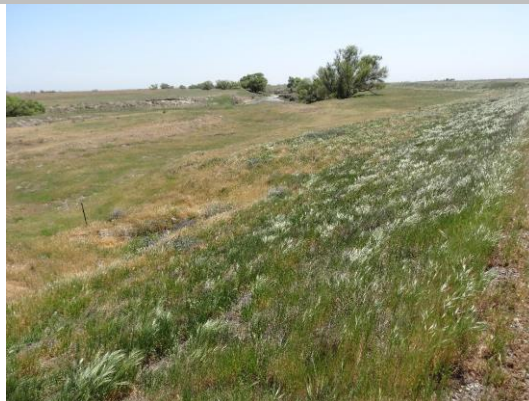
Photo 1 of 3 : UCIP_SP_2017_36610_66436.jpg

FS_ID:36610
 DS_ID:19862
 EP_NO: N/A
 Repair Type: Non-Urgent
 Crossing Status: Found
 UCIP Comments: Dense vegetation limits the inspector's visibility to identify signs of pipe failure (leaks) along the waterward slope. Recommend removing vegetation along waterward slope to conduct proper inspection of structure. Also recommend removing dense vegetation blocking landward headwall.
 FIELD_STRUCT_DESC: 24-inch CM pipe through levee, 10.8 feet below crown. Flap gate on the waterward end. Concrete headwall on both ends. (USACE-1967). This entry matches the Drainage or Irrigation Structure referenced in O&M manual (HLM 4.94).
 FS Date: 4/18/2014

View of waterward side.

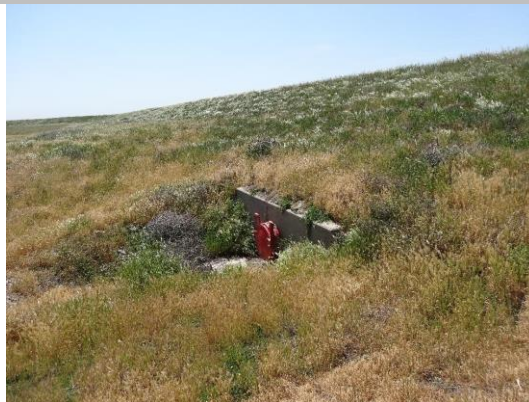
Photo 2 of 3 : UCIP_SP_2017_36610_66438.jpg

View of flap gate, concrete headwall and apron located on waterward side.

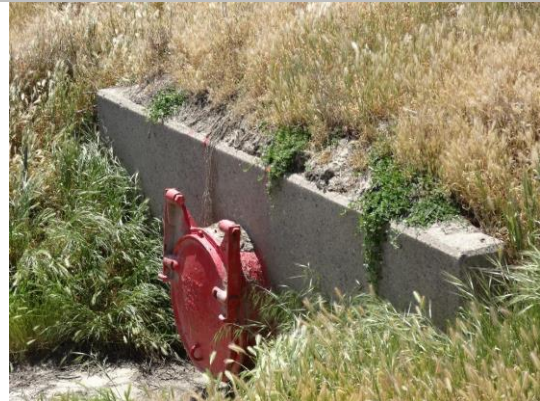
Photo 3 of 3 : UCIP_SP_2017_36610_66437.jpg

Item	DWR UCIP LMA Responsibility			37.242024 °	37.242024 °	
				-120.757602 °	-120.757602 °	
DWR ID						
Comment Code						
Inspector Comment						
FS_ID:36610						
DS_ID:19862						
EP_NO: N/A						
Repair Type: Non-Urgent						
Crossing Status: Found						
UCIP Comments: Dense vegetation limits the inspector's visibility to identify signs of pipe failure (leaks) along the waterward slope. Recommend removing vegetation along waterward slope to conduct proper inspection of structure. Also recommend removing dense vegetation blocking landward headwall.						
FIELD_STRUCT_DESC: 24-inch CM pipe through levee, 10.8 feet below crown. Flap gate on the waterward end. Concrete headwall on both ends. (USACE-1967). This entry matches the Drainage or Irrigation Structure referenced in O&M manual (HLM 4.94).						
FS Date: 4/18/2014

Close up of flap gate located on waterward side.

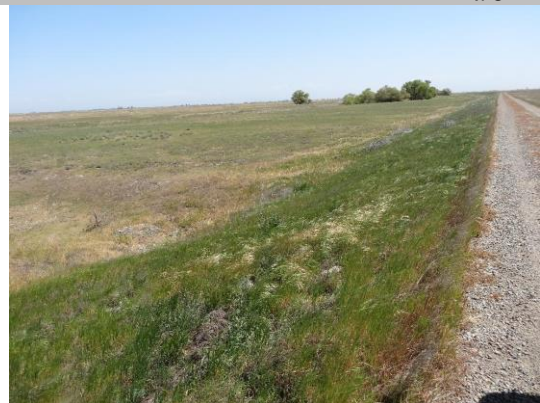
Photo 1 of 3 : UCIP_SP_2017_39875_61599.jpg

LM Start	5.26	Rating **	M	Issue No.	1231
LM End	5.26	Issue Type +	Ma	Location *	LS
Category	Supplemental			GPS Latitude/Longitude	
				Start	End
Item	DWR UCIP LMA Responsibility			37.239098 °	37.239098 °
				-120.751774 °	-120.751774 °
DWR ID					
Comment Code					
Inspector Comment					
FS_ID:39875					
DS_ID:19863					
EP_NO: N/A					
Repair Type: Non-Urgent					
Crossing Status: Found					
UCIP Comments: Clear vegetation from waterward slope and landward headwall.					
FIELD_STRUCT_DESC: 24-inch CM pipe through levee, 10.9 feet below crown. Flap gate on the waterward end. Concrete headwall on both ends. (USACE-1967). This entry matches the Drainage or Irrigation Structure referenced in O&M manual (HLM 5.34).					
FS Date: 4/18/2014

View of waterward side.

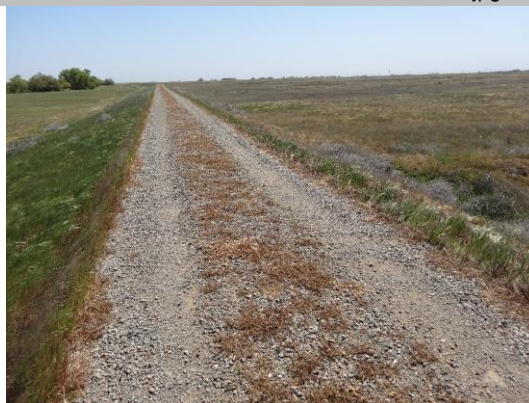
Photo 2 of 3 : UCIP_SP_2017_39875_61598.jpg

LM Start	5.26	Rating **	M	Issue No.	1231 (cont)	
LM End	5.26	Issue Type +	Ma	Location *	LS	
Category	Supplemental			GPS Latitude/Longitude		
				Start		End
Item	DWR UCIP LMA Responsibility			37.239098 °		37.239098 °
				-120.751774 °		-120.751774 °
DWR ID						
Comment Code						
Inspector Comment						
FS_ID:39875						
DS_ID:19863						
EP_NO: N/A						
Repair Type: Non-Urgent						
Crossing Status: Found						
UCIP Comments: Clear vegetation from waterward slope and landward headwall.						
FIELD_STRUCT_DESC: 24-inch CM pipe through levee, 10.9 feet below crown. Flap gate on the waterward end. Concrete headwall on both ends. (USACE-1967). This entry matches the Drainage or Irrigation Structure referenced in O&M manual (HLM 5.34).						
FS Date: 4/18/2014

Overview of levee crown at crossing.

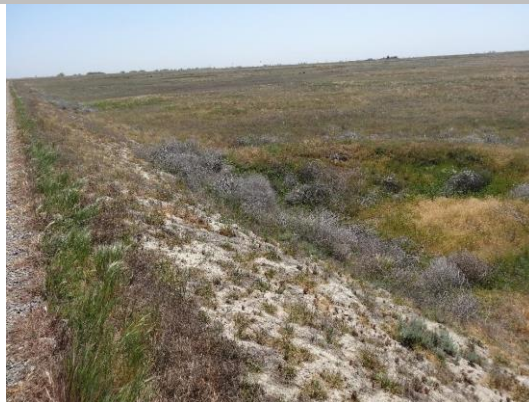
Photo 3 of 3 : UCIP_SP_2017_39875_61597.jpg

View of landward side.

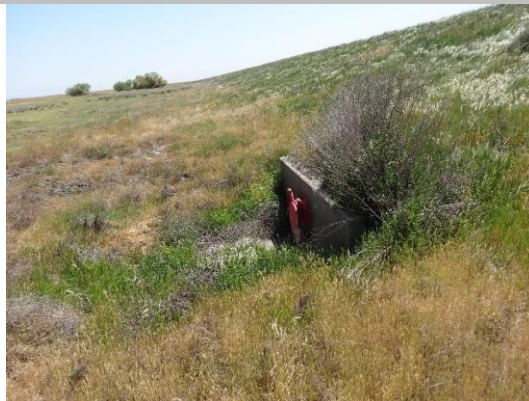
Photo 1 of 3 : UCIP_SP_2017_36611_66441.jpg

Comment Code					
Inspector Comment					
FS_ID:36611 DS_ID:19864 EP_NO: N/A Repair Type: Non-Urgent Crossing Status: Found UCIP Comments: Dense vegetation limits the inspector's visibility to identify signs of pipe failure (leaks) along the waterward slope. Recommend removing vegetation along pipe alignment to conduct proper inspection of structure. Also recommend removing excess vegetation at landward headwall. FIELD_STRUCT_DESC: 24-inch CM pipe through levee, 11.0 feet below crown. Flap gate on the waterward end. Concrete headwall on both ends. (USACE-1967). This entry matches the Drainage or Irrigation Structure referenced in O&M manual (HLM 5.63). FS Date: 4/18/2014

Concrete headwall and flap gate visible on waterward toe.

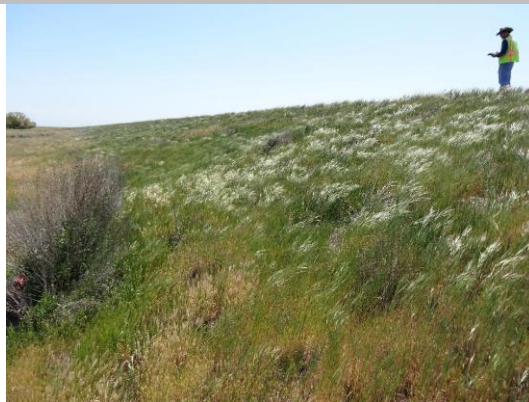
Photo 2 of 3 : UCIP_SP_2017_36611_66440.jpg

View of waterward side--dense vegetation covers slope.

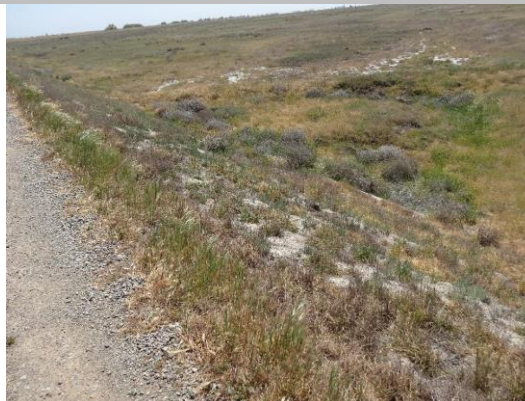
Photo 3 of 3 : UCIP_SP_2017_36611_66439.jpg

Comment Code					
Inspector Comment					
FS_ID:36611 DS_ID:19864 EP_NO: N/A Repair Type: Non-Urgent Crossing Status: Found UCIP Comments: Dense vegetation limits the inspector's visibility to identify signs of pipe failure (leaks) along the waterward slope. Recommend removing vegetation along pipe alignment to conduct proper inspection of structure. Also recommend removing excess vegetation at landward headwall. FIELD_STRUCT_DESC: 24-inch CM pipe through levee, 11.0 feet below crown. Flap gate on the waterward end. Concrete headwall on both ends. (USACE-1967). This entry matches the Drainage or Irrigation Structure referenced in O&M manual (HLM 5.63). FS Date: 4/18/2014

View of landward side.

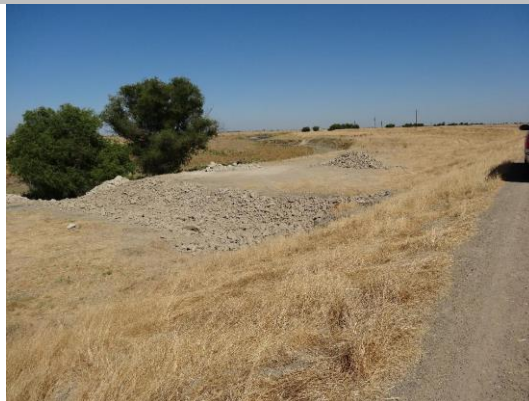
Photo 1 of 3 : UCIP_SP_2017_51312_75493.jpg

FS_ID:51312
DS_ID:19865
EP_NO: N/A
Repair Type: No Action Needed
Crossing Status: Found
UCIP Comments: 7/19/2016 Site has been repaired on WS and LS (see photos below). (DWR UCIP - omagana)5/26/2016 Erosion is undermining the WS headwall of drainage structure (photos of WS headwall provided by DWR Inspector R. Willoughby). Potential pipe failure at the outlet just behind headwall, recommend completing internal wall integrity of pipe length through levee to determine extent of damage to pipe. (DWR UCIP - omagana)4/18/2014 Need to contact owner. Sediment buildup in pipe visible on landside--recommend clearing. (DWR UCIP - omagana)
FIELD_STRUCT_DESC: 24-inch corrugated metal drainage pipe through levee, 9 feet below crown. Concrete headwall on both waterside (WS) and landside (LS) ends. Flap gate on the WS end. [Additional Reference(s): DWR Levee Log, 2002. USACE San Joaquin O&M Manuals: Unit No. 601, 1967, (HLM 6.06), Unit No. 601 Part I, 1967 (Amended in 1978), Unit No. 601 Part II, 1969, and Unit No. 601 Part III, 1969].

View of WS--rock protection along drainage path.

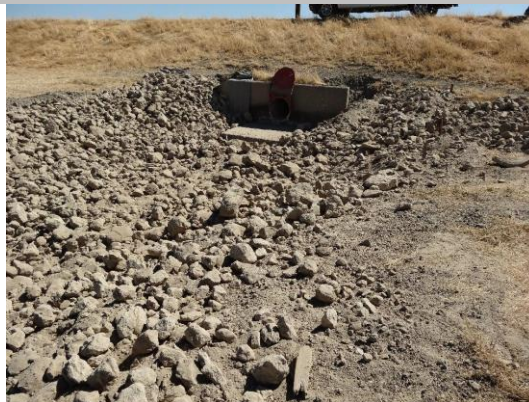
Photo 2 of 3 : UCIP_SP_2017_51312_75488.jpg

WS drainage path protected by rip rap.

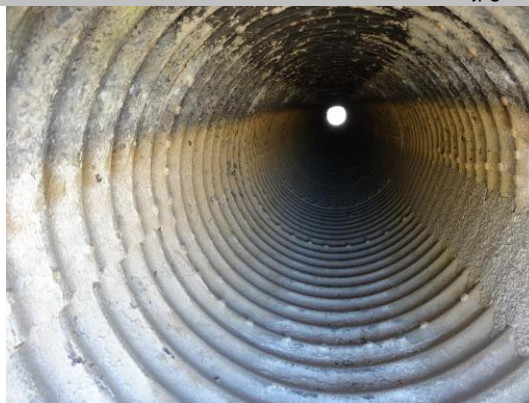
Photo 3 of 3 : UCIP_SP_2017_51312_75489.jpg

Item	DWR UCIP LMA Responsibility			37.236414 °	37.236414 °	
				-120.739735 °	-120.739735 °	
DWR ID						
Comment Code						
Inspector Comment						
FS_ID:51312						
DS_ID:19865						
EP_NO: N/A						
Repair Type: No Action Needed						
Crossing Status: Found						
UCIP Comments: 7/19/2016 Site has been repaired on WS and LS (see photos below). (DWR UCIP - omagana)5/26/2016 Erosion is undermining the WS headwall of drainage structure (photos of WS headwall provided by DWR Inspector R. Willoughby). Potential pipe failure at the outlet just behind headwall, recommend completing internal wall integrity of pipe length through levee to determine extent of damage to pipe. (DWR UCIP - omagana)4/18/2014 Need to contact owner. Sediment buildup in pipe visible on landside--recommend clearing. (DWR UCIP - omagana)						
FIELD_STRUCT_DESC: 24-inch corrugated metal drainage pipe through levee, 9 feet below crown. Concrete headwall on both waterside (WS) and landside (LS) ends. Flap gate on the WS end. [Additional Reference(s): DWR Levee Log, 2002. USACE San Joaquin O&M Manuals: Unit No. 601, 1967, (HLM 6.06), Unit No. 601 Part I, 1967 (Amended in 1978), Unit No. 601 Part II, 1969, and Unit No. 601 Part III, 1969].

Inside view of pipe from WS.

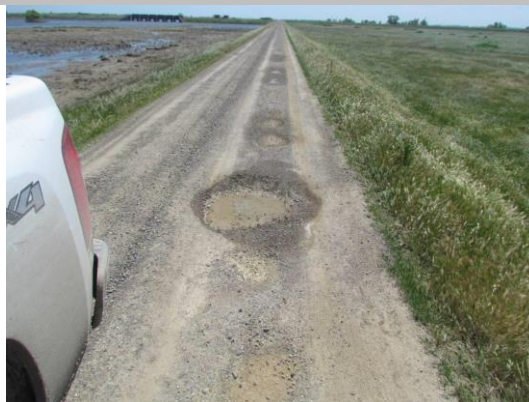
Photo 1 of 2 : SP_2017_NA0010_124_6_20170425_00167.jpg

LM Start	6.44	Rating **	M	Issue No.	6
LM End	11.00	Issue Type +	Ma	Location *	CR
Category	Earthen Levee			GPS Latitude/Longitude	
				Start	End
Item	Crown Surface / Depressions / Rutting			37.233587 °	37.187645 °
				-120.732480 °	-120.676996 °
DWR ID	DWR_NA0010_06_s _ 2012_6				
Comment Code					
C2 : Repair depressions or ruts in the crown or slope.					
Inspector Comment					
Levee crown should be regraded due to excessive rutting and potholes on levee crown..

Looking upstream at large pot hole on levee crown.

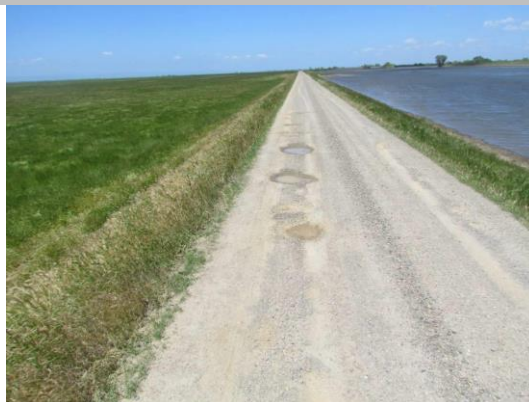
Photo 2 of 2 : SP_2017_NA0010_124_6_20170425_00168.jpg

Looking downstream at typical view of rutting and pot holes on levee crown.

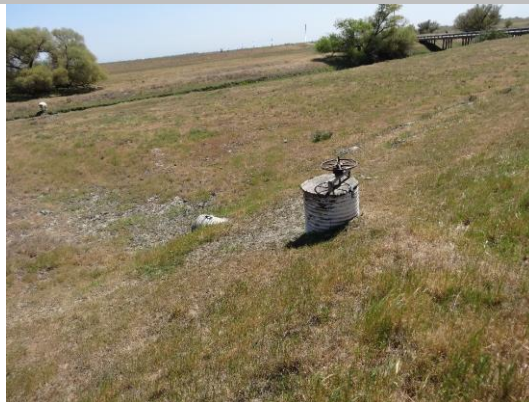
Photo 1 of 3 : UCIP_SP_2017_33984_61628.jpg

LM Start	6.70	Rating **	A/W	Issue No.	1234
LM End	6.70	Issue Type +	Ma	Location *	CR
Category	Supplemental			GPS Latitude/Longitude	
				Start	End
Item	DWR UCIP LMA Responsibility			37.230508 °	37.230508 °
				-120.729634 °	-120.729634 °
DWR ID					
Comment Code					
Inspector Comment					
FS_ID:33984					
DS_ID:19866					
EP_NO: N/A					
Repair Type: No Action Needed					
Crossing Status: Found					
UCIP Comments:					
FIELD_STRUCT_DESC: 24-inch CM pipe through levee, 7.0 feet below crown. Slide gate in 36-inch CM pipe riser in the waterward slope. Concrete headwall on the landward end. Concrete saddle and apron on the waterward end. (USACE-1967). This entry matches the Drainage or Irrigation Structure referenced in O&M manual (HLM 6.79).					
FS Date: 4/18/2014

Slide gate inside CMP riser and pipe visible on waterward side.

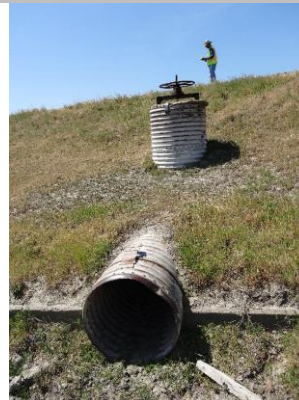
Photo 2 of 3 : UCIP_SP_2017_33984_61627.jpg

Concrete headwall visible on waterward side.

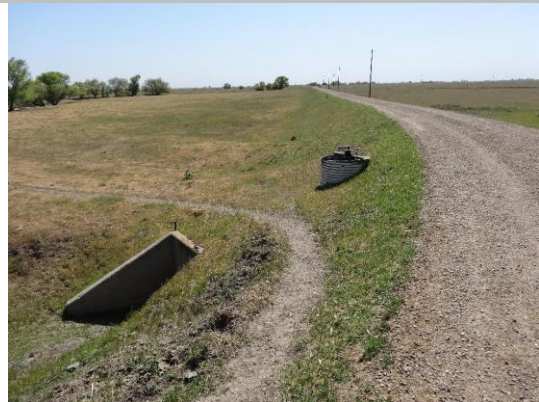
Photo 1 of 3 : UCIP_SP_2017_33985_61640.jpg

LM Start	6.89	Rating **	A/W	Issue No.	1235
LM End	6.89	Issue Type +	Ma	Location *	CR
Category	Supplemental			GPS Latitude/Longitude	
				Start	End
Item	DWR UCIP LMA Responsibility			37.228253 °	37.228253 °
				-120.727865 °	-120.727865 °
DWR ID					
Comment Code					
Inspector Comment					
FS_ID:33985					
DS_ID:19867					
EP_NO: N/A					
Repair Type: No Action Needed					
Crossing Status: Found					
UCIP Comments:					
FIELD_STRUCT_DESC: 36-inch CM pipe through levee, 10.7 feet below crown. Slide gate in 48-inch CM pipe riser in the waterward slope. Concrete headwall on the landward end. Concrete "U" headwall on the waterward end. (USACE-1967). This entry matches the Drainage or Irrigation Structure referenced in O&M manual (HLM 6.97).					
FS Date: 4/18/2014

View of waterward side.
