**Flood Control Project Maintenance
Levee Inspections**

Maintenance Issue Types Only, Levee Inspection Report By Mile - Spring 2017

Lower San Joaquin Levee District

Waterway	Bank	Unit Miles	Inspection Start/End	Inspector
Unit No. 01 San Joaquin River	Right	22.52	04/17/2017 04/20/2017	Richard Willoughby

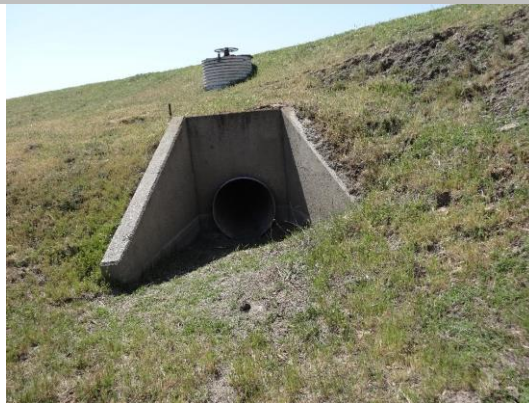
Photo 2 of 3 : UCIP_SP_2017_33985_61639.jpg

LM Start	6.89	Rating **	A/W	Issue No.	1235 (cont)
LM End	6.89	Issue Type +	Ma	Location *	CR
Category	Supplemental			GPS Latitude/Longitude	
				Start	End
Item	DWR UCIP LMA Responsibility			37.228253 °	37.228253 °
				-120.727865 °	-120.727865 °
DWR ID					
Comment Code					
Inspector Comment					
FS_ID:33985					
DS_ID:19867					
EP_NO: N/A					
Repair Type: No Action Needed					
Crossing Status: Found					
UCIP Comments:					
FIELD_STRUCT_DESC: 36-inch CM pipe through levee, 10.7 feet below crown. Slide gate in 48-inch CM pipe riser in the waterward slope. Concrete headwall on the landward end. Concrete "U" headwall on the waterward end. (USACE-1967). This entry matches the Drainage or Irrigation Structure referenced in O&M manual (HLM 6.97).					
FS Date: 4/18/2014

Concrete headwall and CMP riser visible on waterward side.

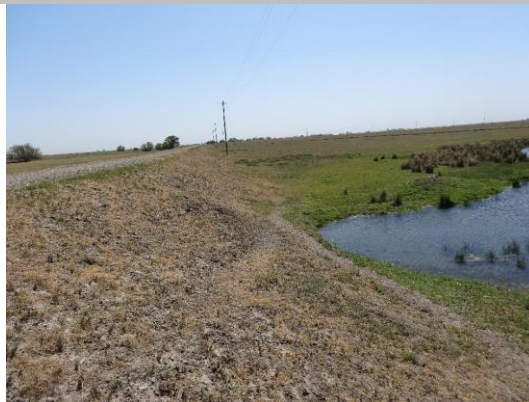
Photo 3 of 3 : UCIP_SP_2017_33985_61638.jpg

View of landward side.

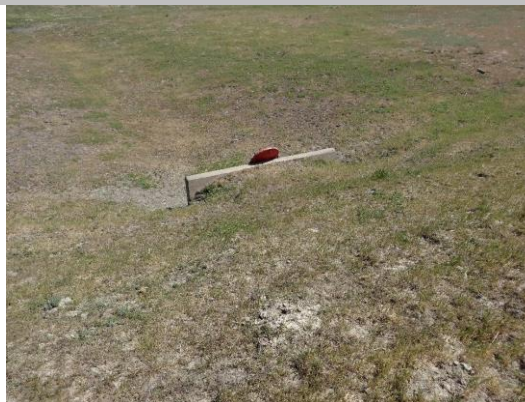
Photo 1 of 3 : UCIP_SP_2017_39471_61650.jpg

LM Start	7.21	Rating **	M	Issue No.	1236
LM End	7.21	Issue Type +	Ma	Location *	LS
Category	Supplemental			GPS Latitude/Longitude	
				Start	End
Item	DWR UCIP LMA Responsibility			37.226102 °	37.226102 °
				-120.722739 °	-120.722739 °
DWR ID					
Comment Code					
Inspector Comment					
FS_ID:39471 DS_ID:19868 EP_NO: N/A Repair Type: Non-Urgent Crossing Status: Found UCIP Comments: Need to contact owner. Clear animal from waterward side. Some sediment buildup in pipe visible landward side--recommend clearing. FIELD_STRUCT_DESC: 24-inch CM pipe through levee, 10.6 feet below crown. Flap gate on the waterward end. Concrete headwall on both ends. (USACE-1967). This entry matches the Drainage or Irrigation Structure referenced in O&M manual (HLM 7.29). FS Date: 4/18/2014

View of waterward side.

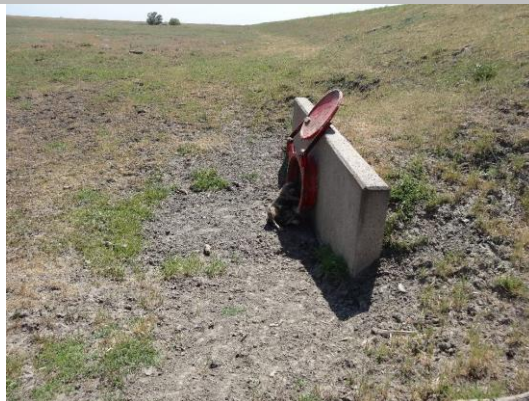
Photo 2 of 3 : UCIP_SP_2017_39471_61649.jpg

LM Start	7.21	Rating **	M	Issue No.	1236 (cont)
LM End	7.21	Issue Type +	Ma	Location *	LS
Category	Supplemental			GPS Latitude/Longitude	
				Start	End
Item	DWR UCIP LMA Responsibility			37.226102 °	37.226102 °
				-120.722739 °	-120.722739 °
DWR ID					
Comment Code					
Inspector Comment					
FS_ID:39471 DS_ID:19868 EP_NO: N/A Repair Type: Non-Urgent Crossing Status: Found UCIP Comments: Need to contact owner. Clear animal from waterward side. Some sediment buildup in pipe visible landward side--recommend clearing. FIELD_STRUCT_DESC: 24-inch CM pipe through levee, 10.6 feet below crown. Flap gate on the waterward end. Concrete headwall on both ends. (USACE-1967). This entry matches the Drainage or Irrigation Structure referenced in O&M manual (HLM 7.29). FS Date: 4/18/2014

Concrete headwall and flap gate visible on waterward side. Dead animal inside pipe.

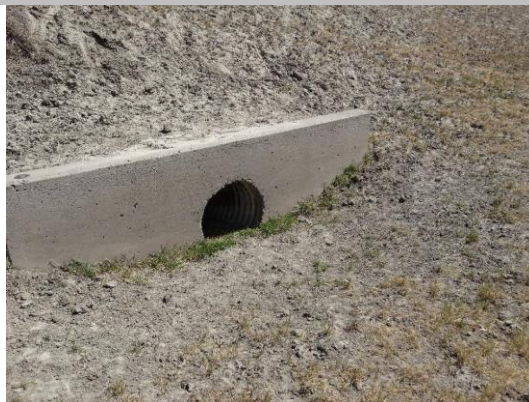
Photo 3 of 3 : UCIP_SP_2017_39471_61648.jpg

View of landward side.

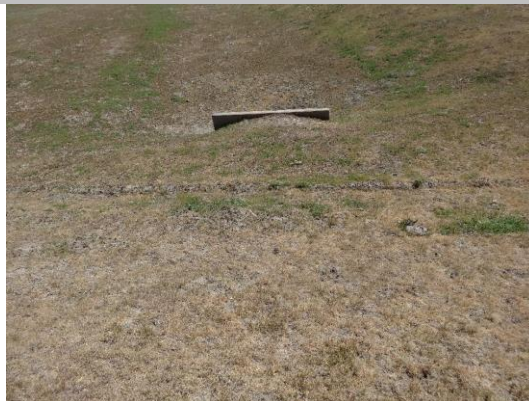
Photo 1 of 3 : UCIP_SP_2017_39472_66462.jpg

FS_ID:39472
DS_ID:19869
EP_NO: N/A
Repair Type: Non-Urgent
Crossing Status: Found
UCIP Comments: Some sediment buildup in pipe visible on landward side--recommend clearing.
FIELD_STRUCT_DESC: 24-inch CM pipe through levee, 11.8 feet below crown. Flap gate on the waterward end. Concrete headwall on both ends. (USACE-1967). This entry matches the Drainage or Irrigation Structure referenced in O&M manual (HLM 7.74). Skewed crossing
FS Date: 4/18/2014

View of waterward side.

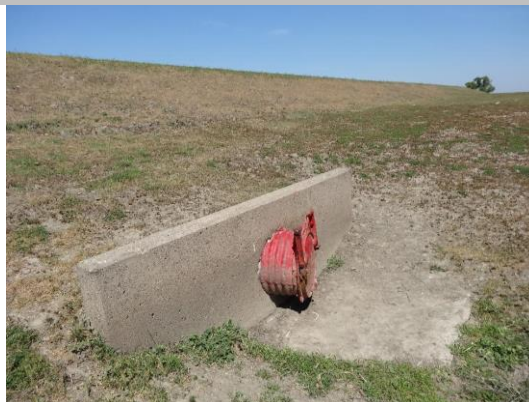
Photo 2 of 3 : UCIP_SP_2017_39472_66461.jpg

Pipe crosses levee at an angle.

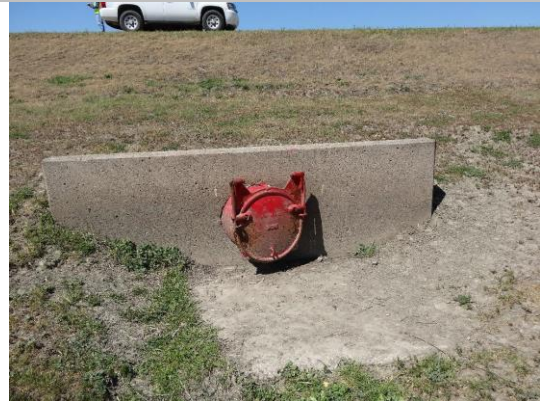
Photo 3 of 3 : UCIP_SP_2017_39472_66460.jpg

LM Start	7.66	Rating **	M	Issue No.	1237 (cont)	
LM End	7.66	Issue Type +	Ma	Location *	LS	
Category	Supplemental			GPS Latitude/Longitude		
				Start	End	
Item	DWR UCIP LMA Responsibility			37.222743 °	37.222743 °	
				-120.716416 °	-120.716416 °	
DWR ID						
Comment Code						
Inspector Comment						
FS_ID:39472 DS_ID:19869 EP_NO: N/A Repair Type: Non-Urgent Crossing Status: Found UCIP Comments: Some sediment buildup in pipe visible on landward side--recommend clearing. FIELD_STRUCT_DESC: 24-inch CM pipe through levee, 11.8 feet below crown. Flap gate on the waterward end. Concrete headwall on both ends. (USACE-1967). This entry matches the Drainage or Irrigation Structure referenced in O&M manual (HLM 7.74). Skewed crossing FS Date: 4/18/2014

Concrete headwall and flap gate visible on waterward side.

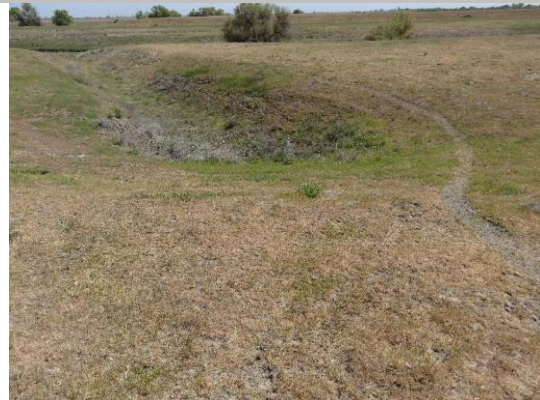
Photo 1 of 3 : UCIP_SP_2017_39473_61674.jpg

LM Start	8.13	Rating **	M	Issue No.	1238
LM End	8.13	Issue Type +	Ma	Location *	LS
Category	Supplemental			GPS Latitude/Longitude	
				Start	End
Item	DWR UCIP LMA Responsibility			37.216547 °	37.216547 °
				-120.713000 °	-120.713000 °
DWR ID					
Comment Code					
Inspector Comment					
FS_ID:39473 DS_ID:19870 EP_NO: N/A Repair Type: Non-Urgent Crossing Status: Found UCIP Comments: Sediment buildup in pipe--recommend contacting owner to clear sediment. FIELD_STRUCT_DESC: 24-inch CM pipe through levee, 16.5 feet below crown. Flap gate on the waterward end. Concrete headwall on both ends. (USACE-1967). This entry matches the Drainage or Irrigation Structure referenced in O&M manual (HLM 8.21). FS Date: 4/18/2014

View of waterward side.

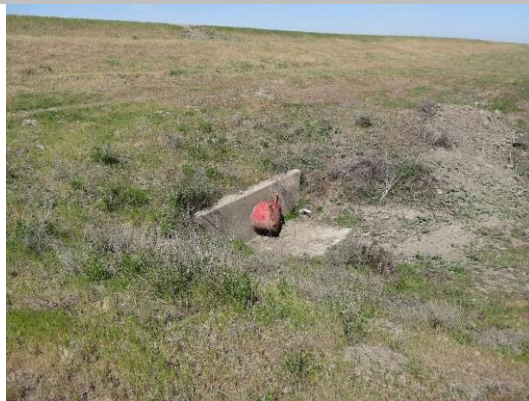
Photo 2 of 3 : UCIP_SP_2017_39473_61673.jpg

LM Start	8.13	Rating **	M	Issue No.	1238 (cont)
LM End	8.13	Issue Type +	Ma	Location *	LS
Category	Supplemental			GPS Latitude/Longitude	
				Start	End
Item	DWR UCIP LMA Responsibility			37.216547 °	37.216547 °
				-120.713000 °	-120.713000 °
DWR ID					
Comment Code					
Inspector Comment					
FS_ID:39473 DS_ID:19870 EP_NO: N/A Repair Type: Non-Urgent Crossing Status: Found UCIP Comments: Sediment buildup in pipe--recommend contacting owner to clear sediment. FIELD_STRUCT_DESC: 24-inch CM pipe through levee, 16.5 feet below crown. Flap gate on the waterward end. Concrete headwall on both ends. (USACE-1967). This entry matches the Drainage or Irrigation Structure referenced in O&M manual (HLM 8.21). FS Date: 4/18/2014

Pipe crosses levee at an angle.

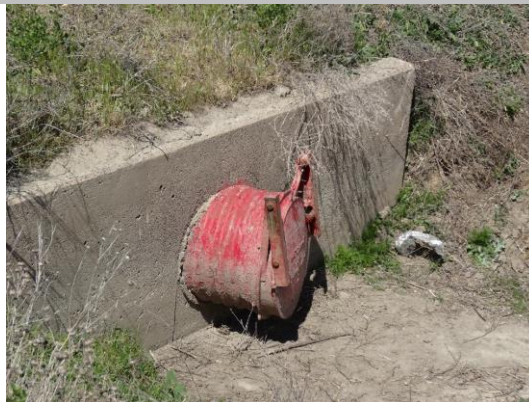
Photo 3 of 3 : UCIP_SP_2017_39473_61672.jpg

Concrete headwall and flap gate visible on waterward side.

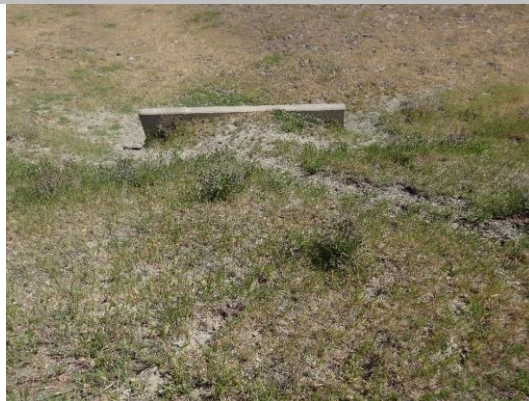
Photo 1 of 3 : UCIP_SP_2017_39474_61685.jpg

FS_ID:39474
DS_ID:19871
EP_NO: N/A
Repair Type: Non-Urgent
Crossing Status: Found
UCIP Comments: Need to contact owner. Sediment buildup in pipe visible on landward side--recommend clearing. Good candidate for pressure test or video inspection due to signs of heavy corrosion. If no leaks after tests this crossing would be a good candidate for rehabilitation.
FIELD_STRUCT_DESC: 24-inch CM pipe through levee, 9.2 feet below crown. Flap gate on the waterward end. Concrete headwall on both ends. (USACE-1967). This entry matches the Drainage or Irrigation Structure referenced in O&M manual (HLM 8.51).
FS Date: 4/18/2014

View of waterward side.

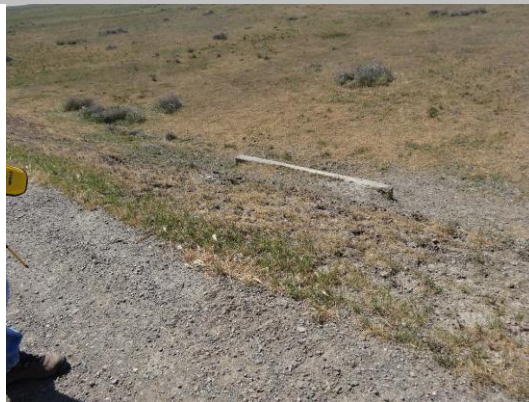
Photo 2 of 3 : UCIP_SP_2017_39474_61684.jpg

View of landward side.

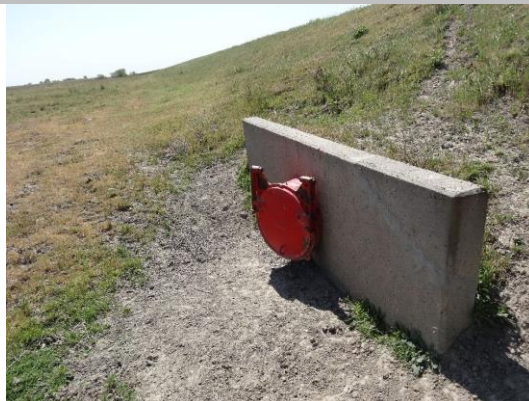
Photo 3 of 3 : UCIP_SP_2017_39474_61683.jpg

Item	DWR UCIP LMA Responsibility			37.213288 °	37.213288 °	
				-120.709503 °	-120.709503 °	
DWR ID						
Comment Code						
Inspector Comment						
FS_ID:39474 DS_ID:19871 EP_NO: N/A Repair Type: Non-Urgent Crossing Status: Found UCIP Comments: Need to contact owner. Sediment buildup in pipe visible on landward side--recommend clearing. Good candidate for pressure test or video inspection due to signs of heavy corrosion. If no leaks after tests this crossing would be a good candidate for rehabilitation. FIELD_STRUCT_DESC: 24-inch CM pipe through levee, 9.2 feet below crown. Flap gate on the waterward end. Concrete headwall on both ends. (USACE-1967). This entry matches the Drainage or Irrigation Structure referenced in O&M manual (HLM 8.51). FS Date: 4/18/2014

Pipe crosses levee at an angle.

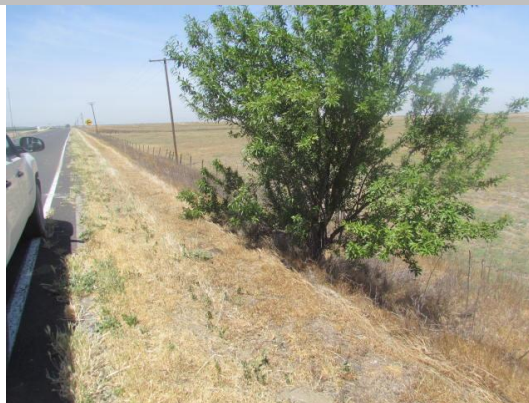
Photo 1 of 1 : SP_2017_NA0010_124_14_20170417_00012.jpg

LM Start	11.49	Rating **	M	Issue No.	14
LM End	11.49	Issue Type +	Ma	Location *	WS
Category	Earthen Levee			GPS Latitude/Longitude	
				Start	End
Item	Trim / Thin Trees			37.186189 °	37.186189 °
				-120.668476 °	-120.668476 °
DWR ID	DWR_NA0010_06_s_2015_14				
Comment Code					
T1 : Trim trees to at least five feet above ground level.					
Inspector Comment					
Almond tree located along Sandy Mush Rd. on waterward slope.

Looking west at tree on waterward slope.

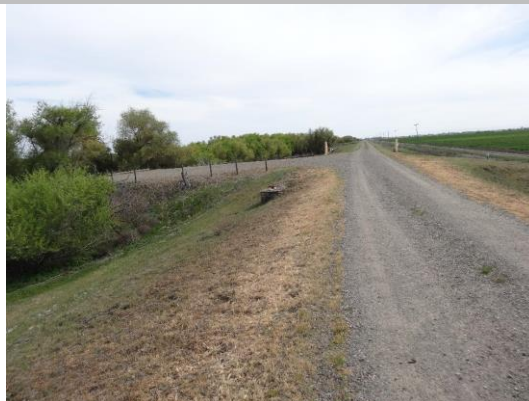
Photo 1 of 3 : UCIP_SP_2017_39476_66488.jpg

LM Start	11.74	Rating **	M	Issue No.	1249
LM End	11.74	Issue Type +	Ma	Location *	WS
Category	Supplemental			GPS Latitude/Longitude	
				Start	End
Item	DWR UCIP LMA Responsibility			37.185513 °	37.185513 °
				-120.664561 °	-120.664561 °
DWR ID					
Comment Code					
Inspector Comment					
FS_ID:39476					
DS_ID:19876					
EP_NO: N/A					
Repair Type: Non-Urgent					
Crossing Status: Found					
UCIP Comments: Clear debris from waterward and landward toes.					
FIELD_STRUCT_DESC: 36-inch CM pipe through levee, 17.0 feet below crown. Slide gate in pipe riser on the waterward slope. (USACE-1967). This entry matches the Drainage or Irrigation Structure referenced in O&M manual (HLM 11.82).					
FS Date: 4/17/2014

View of waterward side.

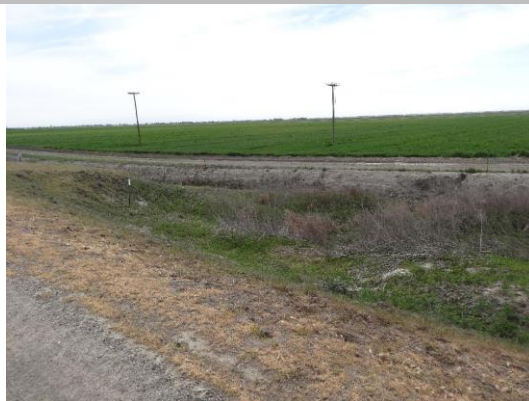
Photo 2 of 3 : UCIP_SP_2017_39476_66487.jpg

View of landward side.

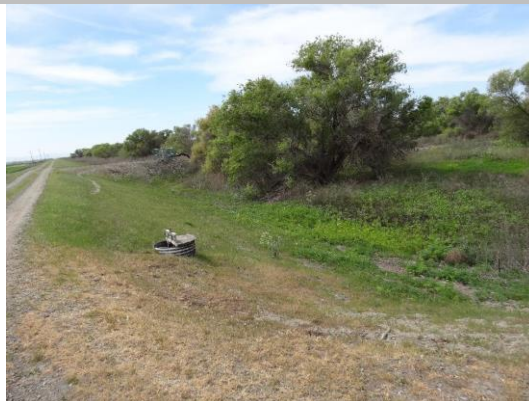
Photo 2 of 3 : UCIP_SP_2017_39477_66494.jpg

LM Start	13.22	Rating **	M	Issue No.	1250 (cont)
LM End	13.22	Issue Type +	Ma	Location *	WS
Category	Supplemental			GPS Latitude/Longitude	
				Start	End
Item	DWR UCIP LMA Responsibility			37.171675 °	37.171675 °
				-120.655064 °	-120.655064 °
DWR ID					
Comment Code					
Inspector Comment					
FS_ID:39477					
DS_ID:19877					
EP_NO: N/A					
Repair Type: Non-Urgent					
Crossing Status: Found					
UCIP Comments: Not accessible--crossing is buried on landward side.					
Need to contact owner to determine status.					
FIELD_STRUCT_DESC: 24-inch CM pipe through levee, 10.8 feet below crown. Flap gate on the waterward end. (USACE-1967). This entry matches the Drainage or Irrigation Structure referenced in O&M manual (HLM 13.30).					
FS Date: 4/17/2014

View of waterward slope.

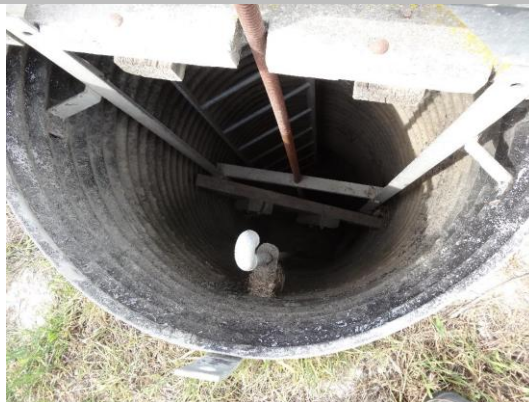
Photo 3 of 3 : UCIP_SP_2017_39477_66495.jpg

Inside view of CMP riser located on waterward slope.

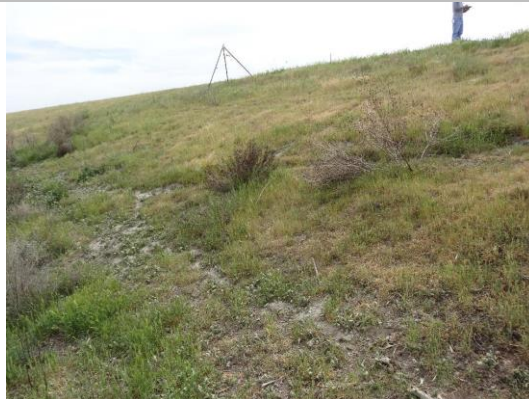
Photo 1 of 3 : UCIP_SP_2017_39478_66496.jpg

LM Start	14.36	Rating **	M	Issue No.	1251
LM End	14.36	Issue Type +	Ma	Location *	WS
Category	Supplemental			GPS Latitude/Longitude	
				Start	End
Item	DWR UCIP LMA Responsibility			37.167888 °	37.167888 °
				-120.636419 °	-120.636419 °
DWR ID					
Comment Code					
Inspector Comment					
FS_ID:39478 DS_ID:19878 EP_NO: N/A Repair Type: Non-Urgent Crossing Status: Found UCIP Comments: Not accessible--crossing is buried on landward side. Need to contact owner to determine status. FIELD_STRUCT_DESC: 24-inch CM pipe through levee, 12.3 feet below crown. Flap gate on the waterward end. (USACE-1967). This entry matches the Drainage or Irrigation Structure referenced in O&M manual (HLM 14.44). FS Date: 4/17/2014

View of waterward slope.

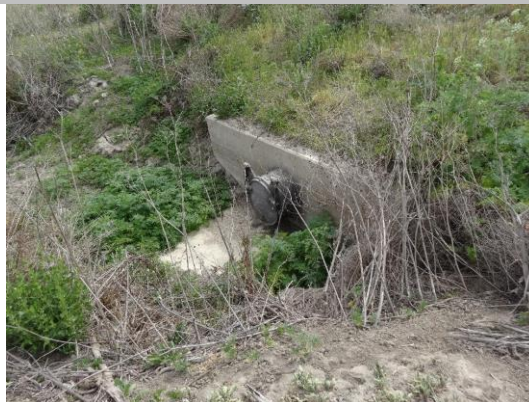
Photo 2 of 3 : UCIP_SP_2017_39478_66497.jpg

View of pipe daylight, flap gate, and concrete headwall visible on waterward toe.

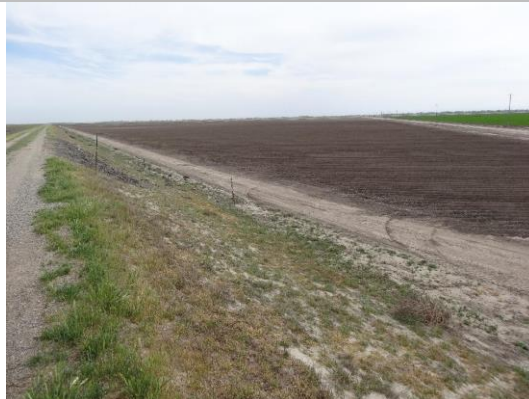
Photo 3 of 3 : UCIP_SP_2017_39478_66498.jpg

LM Start	14.36	Rating **	M	Issue No.	1251 (cont)
LM End	14.36	Issue Type +	Ma	Location *	WS
Category	Supplemental			GPS Latitude/Longitude	
				Start	End
Item	DWR UCIP LMA Responsibility			37.167888 °	37.167888 °
				-120.636419 °	-120.636419 °
DWR ID					
Comment Code					
Inspector Comment					
FS_ID:39478 DS_ID:19878 EP_NO: N/A Repair Type: Non-Urgent Crossing Status: Found UCIP Comments: Not accessible--crossing is buried on landward side. Need to contact owner to determine status. FIELD_STRUCT_DESC: 24-inch CM pipe through levee, 12.3 feet below crown. Flap gate on the waterward end. (USACE-1967). This entry matches the Drainage or Irrigation Structure referenced in O&M manual (HLM 14.44). FS Date: 4/17/2014

View of landward slope.

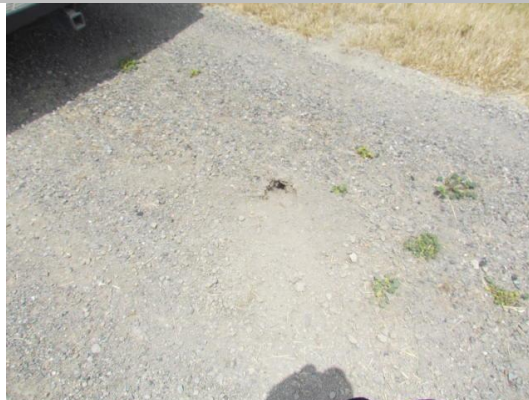
Photo 1 of 1 : SP_2017_NA0010_124_1212_20170417_00034.jpg

LM Start	14.94	Rating **	M	Issue No.	1212
LM End	14.94	Issue Type +	Ma	Location *	CR
Category	Earthen Levee			GPS Latitude/Longitude	
				Start	End
Item	Animal Control			37.162287 °	37.162287 °
				-120.628791 °	-120.628791 °
DWR ID	DWR_NA0010_06_s _ 2015_1212				
Comment Code					
A3 : No rodents visible, but rodent burrows visible; need to backfill and compact or grout burrows.					
Inspector Comment					
Several rodent holes noted on levee crown and landside and waterside slopes.

Looking at rodent hole on levee crown.

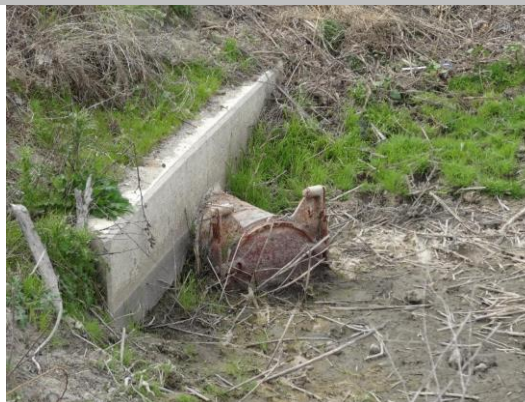
Photo 1 of 3 : UCIP_SP_2017_39480_66507.jpg

LM Start	15.68	Rating **	M	Issue No.	1252
LM End	15.68	Issue Type +	Ma	Location *	LS
Category	Supplemental			GPS Latitude/Longitude	
				Start	End
Item	DWR UCIP LMA Responsibility			37.156934 °	37.156934 °
				-120.617210 °	-120.617210 °
DWR ID					
Comment Code					
Inspector Comment					
FS_ID:39480 DS_ID:19884 EP_NO: N/A Repair Type: Non-Urgent Crossing Status: Found UCIP Comments: Need to contact owner. Sediment buildup on both the waterward and landward side. Recommend removing sediment buildup from both side. Also recommend clearing excess sediment inside crossing. FIELD_STRUCT_DESC: 24-inch CM pipe through levee, 14.0 feet below crown. Flap gate on the waterward end. (USACE-1967). This entry matches the Drainage or Irrigation Structure referenced in O&M manual (HLM 15.76). FS Date: 4/17/2014

Flap gate buried halfway on waterward side.

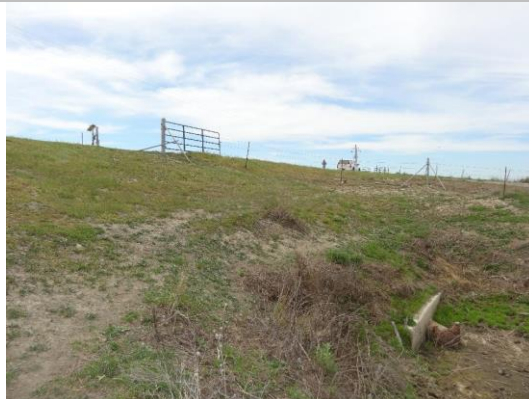
Photo 2 of 3 : UCIP_SP_2017_39480_66506.jpg

LM Start	15.68	Rating **	M	Issue No.	1252 (cont)
LM End	15.68	Issue Type +	Ma	Location *	LS
Category	Supplemental			GPS Latitude/Longitude	
				Start	End
Item	DWR UCIP LMA Responsibility			37.156934 °	37.156934 °
				-120.617210 °	-120.617210 °
DWR ID					
Comment Code					
Inspector Comment					
FS_ID:39480 DS_ID:19884 EP_NO: N/A Repair Type: Non-Urgent Crossing Status: Found UCIP Comments: Need to contact owner. Sediment buildup on both the waterward and landward side. Recommend removing sediment buildup from both side. Also recommend clearing excess sediment inside crossing. FIELD_STRUCT_DESC: 24-inch CM pipe through levee, 14.0 feet below crown. Flap gate on the waterward end. (USACE-1967). This entry matches the Drainage or Irrigation Structure referenced in O&M manual (HLM 15.76). FS Date: 4/17/2014

View of waterward side.

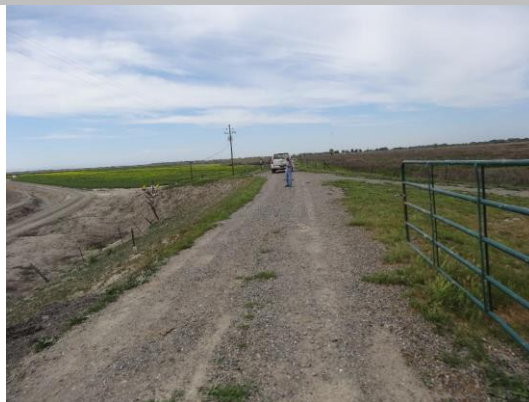
Photo 3 of 3 : UCIP_SP_2017_39480_66505.jpg

Overview of levee crown at crossing.

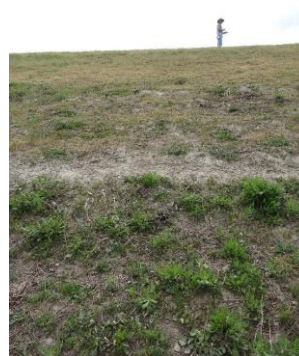
Photo 1 of 3 : UCIP_SP_2017_36663_66530.jpg

LM Start	15.82	Rating **	M	Issue No.	1253
LM End	15.82	Issue Type +	Ma	Location *	LS
Category	Supplemental			GPS Latitude/Longitude	
				Start	End
Item	DWR UCIP LMA Responsibility			37.155539 °	37.155539 °
				-120.615303 °	-120.615303 °
DWR ID					
Comment Code					
Inspector Comment					
FS_ID:36663 DS_ID:19885 EP_NO: N/A Repair Type: Non-Urgent Crossing Status: Found UCIP Comments: Need to contact owner to determine status of crossing. Waterward side is buried and not accessible. Landward side headwall is blocked by dense vegetation. Recommend confirming status of flap gate on waterward side and removing dense vegetation form landward side. FIELD_STRUCT_DESC: 36-inch CM pipe through levee, 16.6 feet below crown. Flap gate on the waterward end. (USACE-1967). This entry matches the Drainage or Irrigation Structure referenced in O&M manual (HLM 15.91). FS Date: 4/17/2014

View of waterward side, Photo 1 of 3.

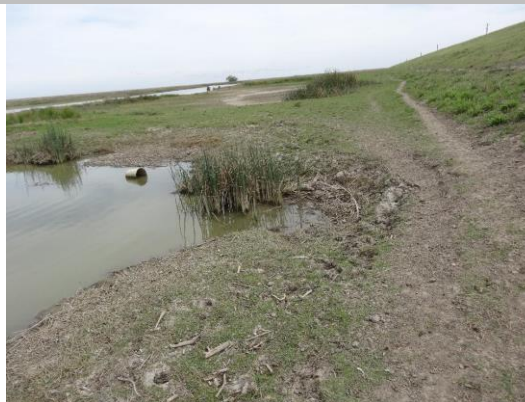
Photo 2 of 3 : UCIP_SP_2017_36663_66526.jpg

View of waterward side, photo 2 of 3.

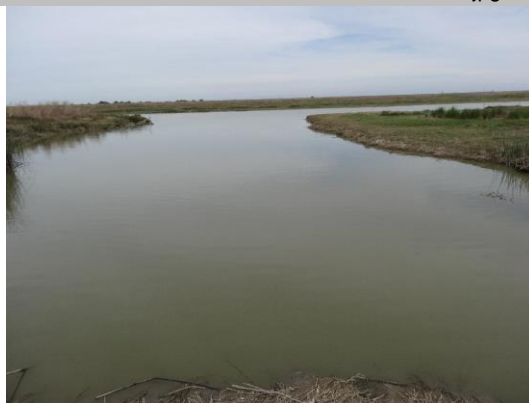
Photo 3 of 3 : UCIP_SP_2017_36663_66529.jpg

Item	DWR UCIP LMA Responsibility			37.155539 °		37.155539 °
				-120.615303 °		-120.615303 °
DWR ID						
Comment Code						
Inspector Comment						
FS_ID:36663 DS_ID:19885 EP_NO: N/A Repair Type: Non-Urgent Crossing Status: Found UCIP Comments: Need to contact owner to determine status of crossing. Waterward side is buried and not accessible. Landward side headwall is blocked by dense vegetation. Recommend confirming status of flap gate on waterward side and removing dense vegetation form landward side. FIELD_STRUCT_DESC: 36-inch CM pipe through levee, 16.6 feet below crown. Flap gate on the waterward end. (USACE-1967). This entry matches the Drainage or Irrigation Structure referenced in O&M manual (HLM 15.91). FS Date: 4/17/2014

View of waterward side, photo 3 of 3.

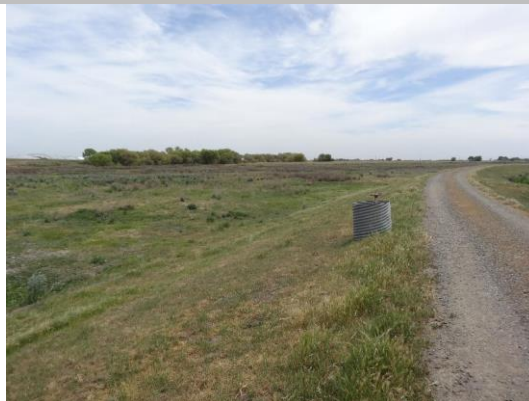
Photo 1 of 3 : UCIP_SP_2017_36687_66579.jpg

LM Start	18.89	Rating **	M	Issue No.	1257
LM End	18.89	Issue Type +	Ma	Location *	LS
Category	Supplemental			GPS Latitude/Longitude	
				Start	End
Item	DWR UCIP LMA Responsibility			37.118178 °	37.118178 °
				-120.586783 °	-120.586783 °
DWR ID					
Comment Code					
Inspector Comment					
FS_ID:36687 DS_ID:19889 EP_NO: N/A Repair Type: Non-Urgent Crossing Status: Found UCIP Comments: Dense vegetation limits the inspector's visibility to identify signs of pipe failure (leaks) along the landward slope. Recommend removing vegetation along pipe alignment to conduct proper inspection of structure. FIELD_STRUCT_DESC: 24-inch CM pipe through levee, 10.2 feet below crown. Slide gate in pipe riser on the waterward slope. (USACE-1967). This entry matches the Drainage or Irrigation Structure referenced in O&M manual (HLM 18.97). FS Date: 4/17/2014

View of waterward side.

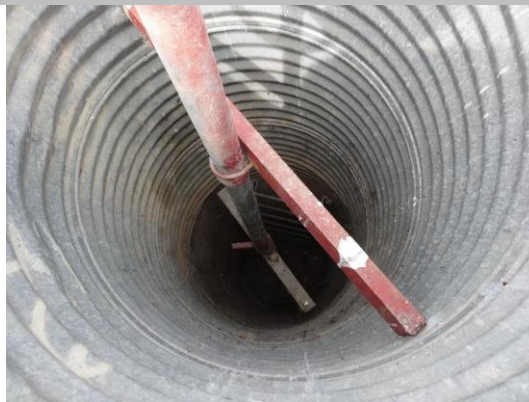
Photo 2 of 3 : UCIP_SP_2017_36687_66582.jpg

Inside view of CMP riser located on waterward slope.

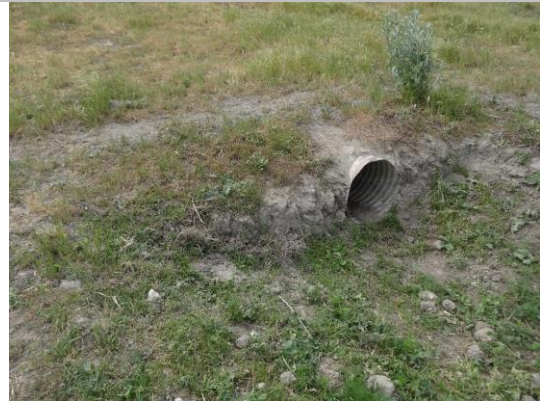
Photo 3 of 3 : UCIP_SP_2017_36687_66581.jpg

LM Start	18.89	Rating **	M	Issue No.	1257 (cont)
LM End	18.89	Issue Type +	Ma	Location *	LS
Category	Supplemental			GPS Latitude/Longitude	
				Start	End
Item	DWR UCIP LMA Responsibility			37.118178 °	37.118178 °
				-120.586783 °	-120.586783 °
DWR ID					
Comment Code					
Inspector Comment					
FS_ID:36687 DS_ID:19889 EP_NO: N/A Repair Type: Non-Urgent Crossing Status: Found UCIP Comments: Dense vegetation limits the inspector's visibility to identify signs of pipe failure (leaks) along the landward slope. Recommend removing vegetation along pipe alignment to conduct proper inspection of structure. FIELD_STRUCT_DESC: 24-inch CM pipe through levee, 10.2 feet below crown. Slide gate in pipe riser on the waterward slope. (USACE-1967). This entry matches the Drainage or Irrigation Structure referenced in O&M manual (HLM 18.97). FS Date: 4/17/2014

Pipe daylight on waterward side.

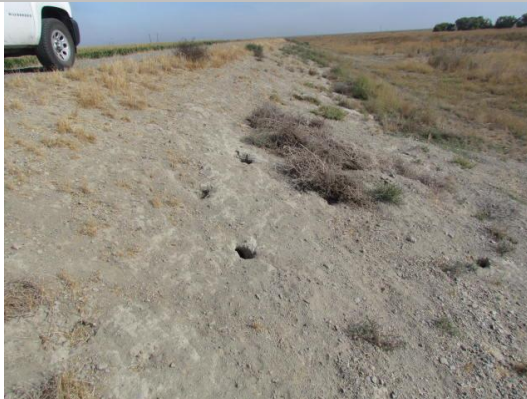
Photo 2 of 5 : SP_2017_NA0010_124_1211_20170417_00030.jpg

LM Start	19.14	Rating **	U	Issue No.	1211 (cont)
LM End	19.14	Issue Type +	Ma	Location *	WS
Category	Earthen Levee			GPS Latitude/Longitude	
				Start	End
Item	Animal Control			37.114793 °	37.114793 °
				-120.587582 °	-120.587582 °
DWR ID	DWR_NA0010_06_s_2015_1211				
Comment Code					
A1 : Exterminate rodents and backfill and compact or grout burrows.					
Inspector Comment					
Several large rodent holes with more than 2 cubic feet of material was noted on waterward slope

Looking at several rodent holes on waterward slope. (Fall 2015)

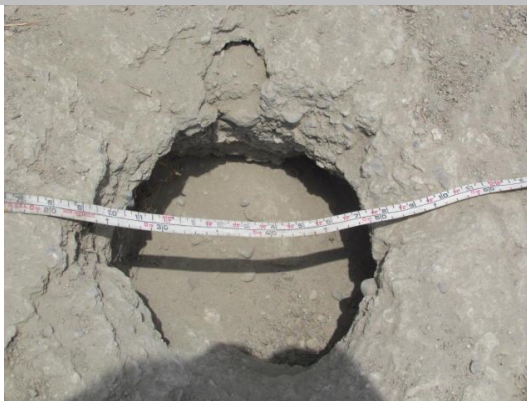
Photo 3 of 5 : SP_2017_NA0010_124_1211_20170417_00031.jpg

Looking at close-up view of large rodent hole on waterward slope. (Spring 2015)

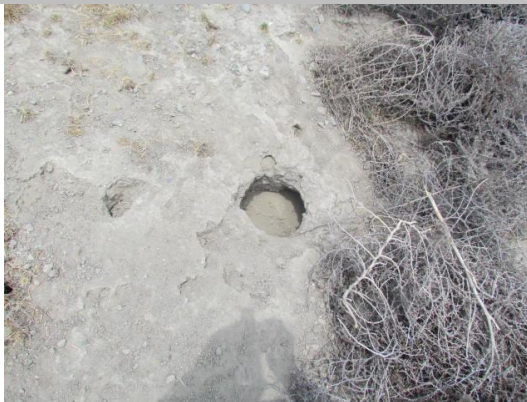
Photo 4 of 5 : SP_2017_NA0010_124_1211_20170417_00032.jpg

Looking at large rodent hole on waterward slope. Spring 2015

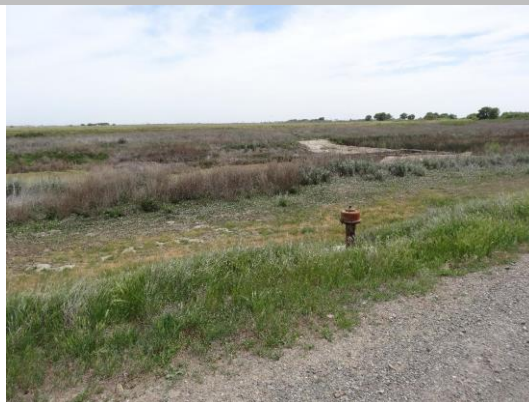
Photo 1 of 3 : UCIP_SP_2017_36688_66583.jpg

LM Start	19.28	Rating **	M	Issue No.	1258
LM End	19.28	Issue Type +	Ma	Location *	WS
Category	Supplemental			GPS Latitude/Longitude	
				Start	End
Item	DWR UCIP LMA Responsibility			37.112902 °	37.112902 °
				-120.588751 °	-120.588751 °
DWR ID					
Comment Code					
Inspector Comment					
FS_ID:36688 DS_ID:19890 EP_NO: N/A Repair Type: Non-Urgent Crossing Status: Found UCIP Comments: Dense vegetation limits the inspector's visibility to identify signs of pipe failure (leaks) along the slopes. Recommend removing vegetation along pipe alignment to conduct proper inspection of structure. FIELD_STRUCT_DESC: 48-inch CM pipe through levee, 20.0 feet below crown. Slide gate in pipe riser on the waterward slope. (USACE-1967). This entry matches the Drainage or Irrigation Structure referenced in O&M manual (HLM 19.36). Rip rap along landward slope. FS Date: 4/17/2014

View of waterward side.

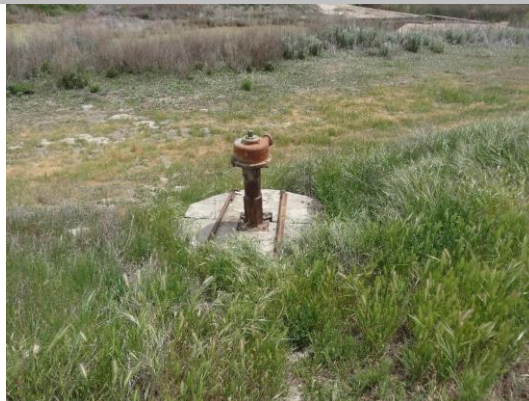
Photo 2 of 3 : UCIP_SP_2017_36688_66584.jpg

FS_ID:36688
DS_ID:19890
EP_NO: N/A
Repair Type: Non-Urgent
Crossing Status: Found
UCIP Comments: Dense vegetation limits the inspector's visibility to identify signs of pipe failure (leaks) along the slopes. Recommend removing vegetation along pipe alignment to conduct proper inspection of structure.
FIELD_STRUCT_DESC: 48-inch CM pipe through levee, 20.0 feet below crown. Slide gate in pipe riser on the waterward slope. (USACE-1967). This entry matches the Drainage or Irrigation Structure referenced in O&M manual (HLM 19.36). Rip rap along landward slope.
FS Date: 4/17/2014

Riser located on waterward slope.

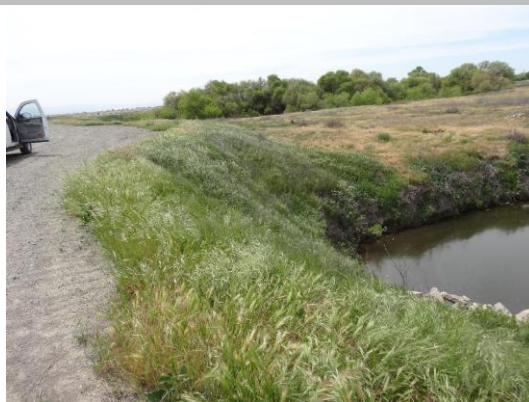
Photo 3 of 3 : UCIP_SP_2017_36688_66586.jpg

View of landward slope.

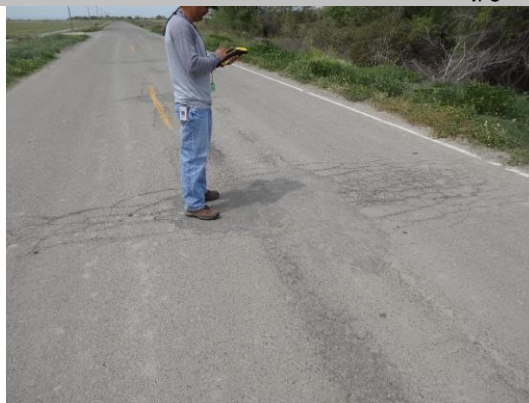
Photo 1 of 3 : UCIP_SP_2017_36689_66591.jpg

Overview of levee crown looking downstream.

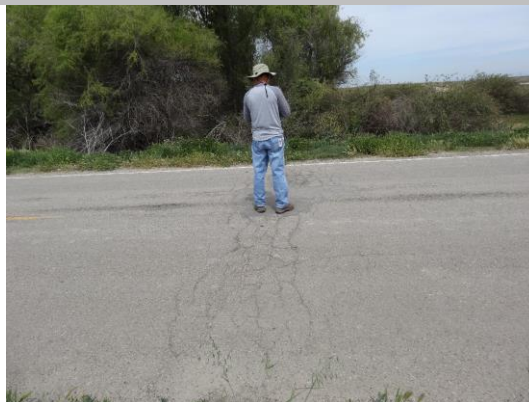
Photo 2 of 3 : UCIP_SP_2017_36689_66592.jpg

View of levee crown at crossing.

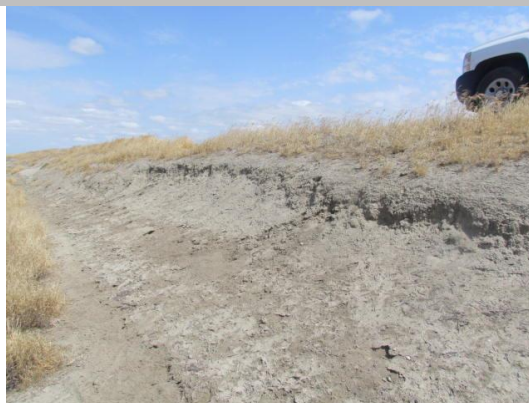
Photo 2 of 2 : SP_2017_NA0010_124_1209_20170417_00028.jpg

LM Start	20.79	Rating **	U	Issue No.	1209 (cont)	
LM End	20.88	Issue Type +	Ma	Location *	LS	
Category	Earthen Levee			GPS Latitude/Longitude		
				Start		End
Item	Erosion / Bank Caving			37.113107 °		37.112176 °
				-120.563782 °		-120.562516 °
DWR ID	DWR_NA0010_06_s _ 2015_1209					
Comment Code						
E1 : Note and monitor erosion site.						
Inspector Comment						
Erosion on landward slope greater than 3 inches. Erosion caused by livestock.

Looking northeast at livestock erosion on landward slope.

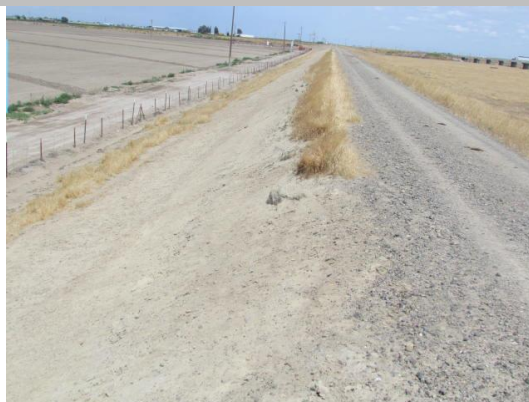
Photo 1 of 3 : SP_2017_NA0010_124_5_20170417_00007.jpg

LM Start	24.58	Rating **	M	Issue No.	5
LM End	24.93	Issue Type +	Ma	Location *	LS
Category	Earthen Levee			GPS Latitude/Longitude	
				Start	End
Item	Slope Stability			37.071198 °	°
				-120.519220 °	°
DWR ID	DWR_NA0010_06_s _ 2012_5				
Comment Code					
S2 : Repair the levee slope damaged by foot traffic and prevent access where possible.					
Inspector Comment					
Landside erosion caused by livestock.

Looking north at livestock erosion on landward slope. (Spring 2015)

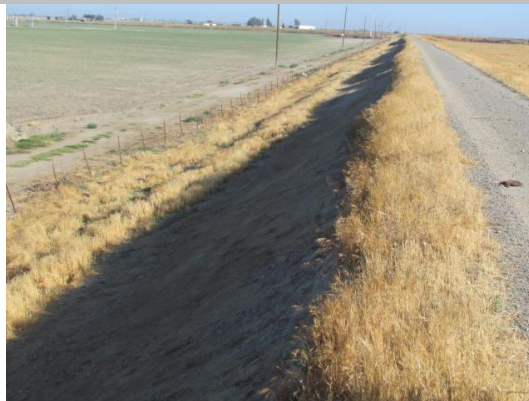
Photo 2 of 3 : SP_2017_NA0010_124_5_20170417_00008.jpg

Looking north at livestock erosion on landward slope. (Spring 2014)

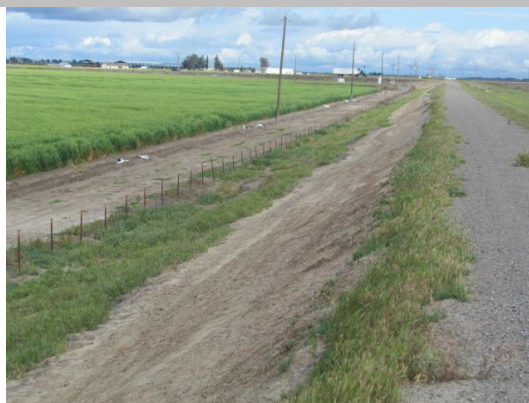
Photo 3 of 3 : SP_2017_NA0010_124_5_20170417_00009.jpg

Looking north at livestock erosion on landside slope. (Fall 2014)

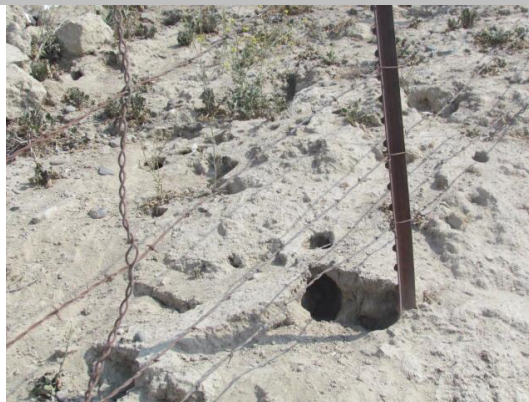
Photo 1 of 1 : SP_2017_NA0010_124_1208_20170417_00026.jpg

LM Start	26.13	Rating **	M	Issue No.	1208
LM End	26.13	Issue Type +	Ma	Location *	LS
Category	Earthen Levee			GPS Latitude/Longitude	
				Start	End
Item	Animal Control			37.054222 °	37.054222 °
				-120.500862 °	-120.500862 °
DWR ID	DWR_NA0010_06_s_2015_1208				
Comment Code					
A1 : Exterminate rodents and backfill and compact or grout burrows.					
Inspector Comment					
Noted several rodent holes next to and within rock revetment on landward slope.

Rodent holes on landward slope.

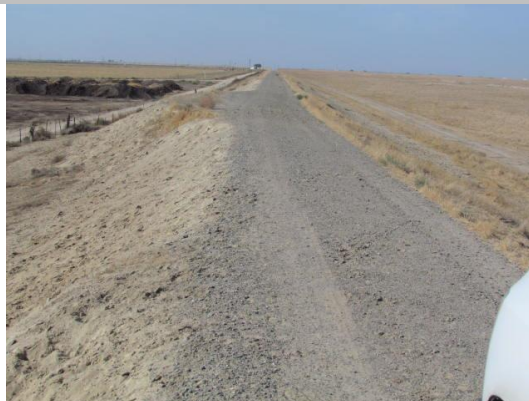
Photo 1 of 4 : SP_2017_NA0010_124_3_20170417_00003.jpg

LM Start	27.64	Rating **	M	Issue No.	3
LM End	27.97	Issue Type +	Ma	Location *	LS
Category	Earthen Levee			GPS Latitude/Longitude	
				Start	End
Item	Slope Stability			37.036955 °	37.032887 °
				-120.484395 °	-120.481225 °
DWR ID	DWR_NA0010_06_s_2012_3				
Comment Code					
S2 : Repair the levee slope damaged by foot traffic and prevent access where possible.					
Inspector Comment					
Landside erosion caused by livestock. Erosion greater than 3" in depth on landward slope. Levee crown has narrowed within this reach.

Looking north at livestock erosion on landward slope. Fall 2015

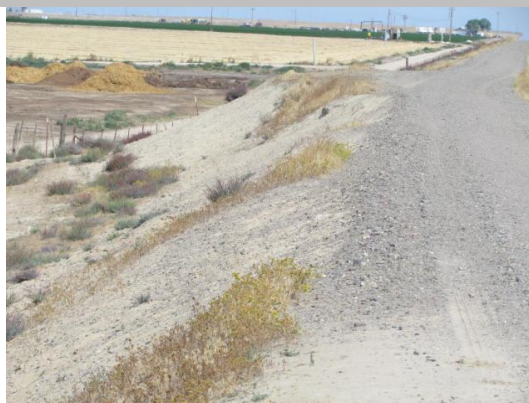
Photo 2 of 4 : SP_2017_NA0010_124_3_20170417_00004.jpg

Looking north at livestock erosion on landward shoulder and slope.(Spring 2015)

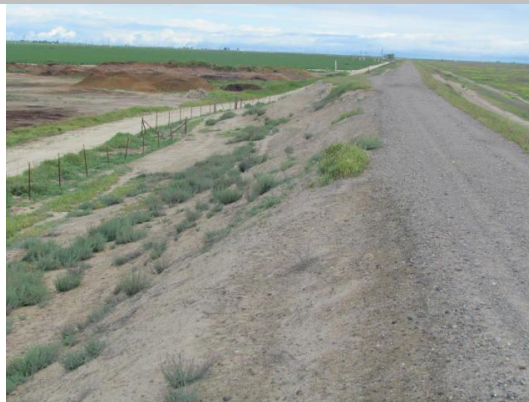
Photo 3 of 4 : SP_2017_NA0010_124_3_20170417_00005.jpg

Looking north at livestock erosion on landside shoulder and slope. (Fall 2014)

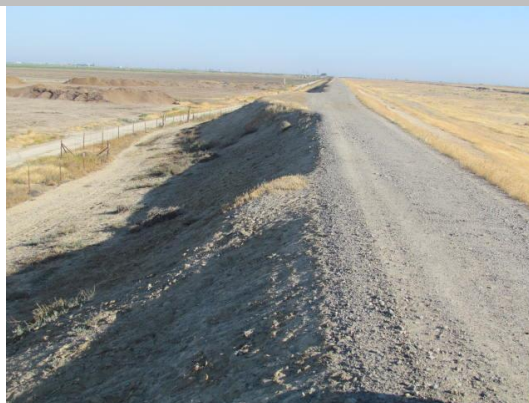
Photo 4 of 4 : SP_2017_NA0010_124_3_20170417_00006.jpg

LM Start	27.64	Rating **	M	Issue No.	3 (cont)	
LM End	27.97	Issue Type +	Ma	Location *	LS	
Category	Earthen Levee			GPS Latitude/Longitude		
				Start		End
Item	Slope Stability			37.036955 °		37.032887 °
				-120.484395 °		-120.481225 °
DWR ID	DWR_NA0010_06_s _ 2012_3					
Comment Code						
S2 : Repair the levee slope damaged by foot traffic and prevent access where possible.						
Inspector Comment						
Landside erosion caused by livestock. Erosion greater than 3" in depth on landward slope. Levee crown has narrowed within this reach.

Looking north at livestock erosion on landward slope. (Spring 2013)

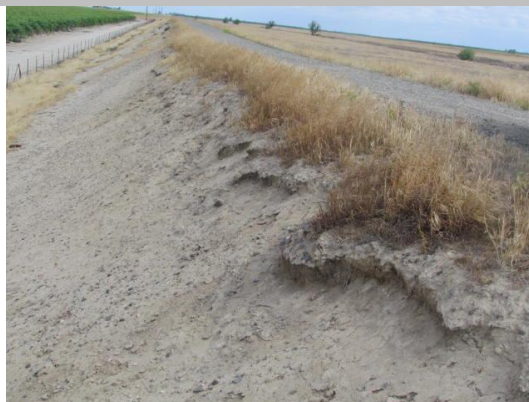
Photo 1 of 2 : SP_2017_NA0010_124_1207_20170417_00024.jpg

LM Start	30.81	Rating **	U	Issue No.	1207
LM End	31.06	Issue Type +	Ma	Location *	LS
Category	Earthen Levee			GPS Latitude/Longitude	
				Start	End
Item	Erosion / Bank Caving			37.021615 °	37.018428 °
				-120.437587 °	-120.435378 °
DWR ID	DWR_NA0010_06_s _ 2015_1207				
Comment Code					
E1 : Note and monitor erosion site.					
Inspector Comment					
Landward erosion greater than 1" in depth and greater than 3" in length. Erosion caused by livestock traffic.

Looking northeast at livestock erosion on landward slope.

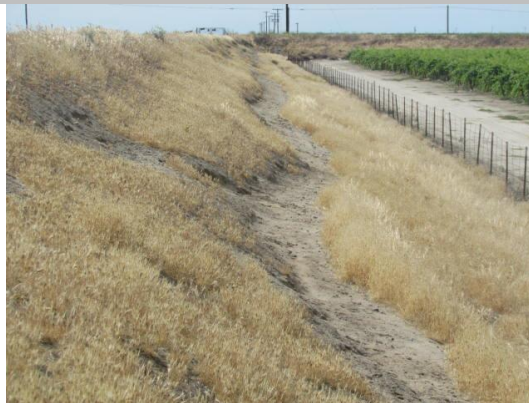
Photo 2 of 2 : SP_2017_NA0010_124_1207_20170417_00025.jpg

Looking south at livestock erosion on landward slope.

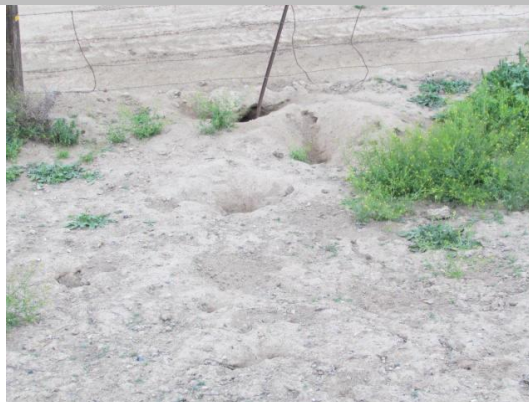
Photo 1 of 2 : SP_2017_NA0010_124_2_20170417_00001.jpg

LM Start	31.10	Rating **	U	Issue No.	2
LM End	31.10	Issue Type +	Ma	Location *	LS
Category	Earthen Levee			GPS Latitude/Longitude	
				Start	End
Item	Animal Control			37.017955 °	37.017955 °
				-120.435017 °	-120.435017 °
DWR ID	DWR_NA0010_06_s_2012_2				
Comment Code					
A1 : Exterminate rodents and backfill and compact or grout burrows.					
Inspector Comment

Looking west at rodent holes on landside slope and toe near fence line.

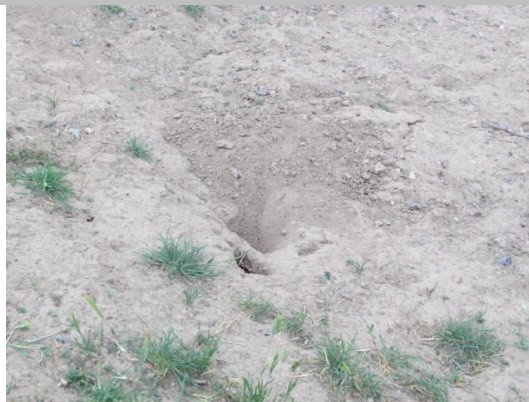
Photo 2 of 2 : SP_2017_NA0010_124_2_20170417_00002.jpg

Looking at typical rodent hole on landside slope.

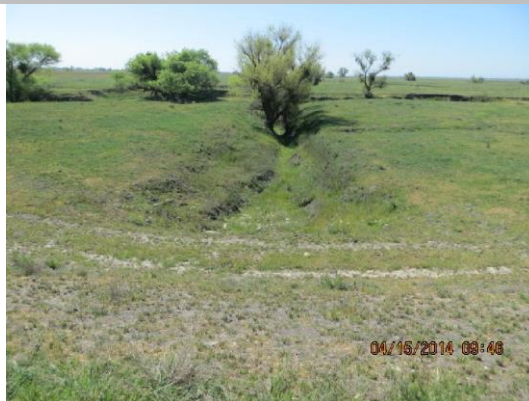
Photo 1 of 3 : UCIP_SP_2017_49966_60954.jpg

Pipe and headwall at WS toe.

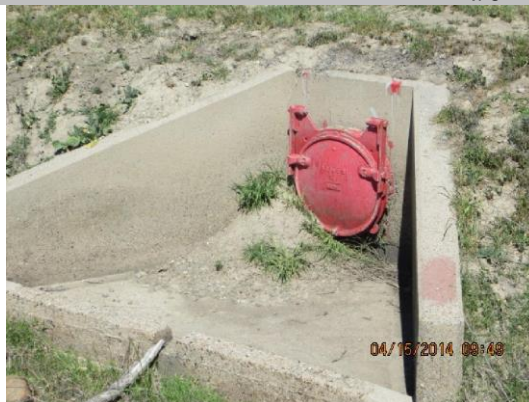
Photo 2 of 3 : UCIP_SP_2017_49966_60955.jpg

FS_ID:49966
DS_ID:19892
EP_NO: N/A
Repair Type: Non-Urgent
Crossing Status: Found
UCIP Comments: 07/20/2016 Inlet blocked off by wooden board. Dense vegetation limits the inspector's visibility to identify signs of pipe failure (leaks) along WS and LS. Crossing downgraded from Urgent to Non-Urgent. (DWR UCIP - omagana)04/15/2014 Flapgate partially blocked by soil buildup at WS toe. (DWR UCIP - omagana)
FIELD_STRUCT_DESC: 24-inch corrugated metal drainage pipe through the levee, 10.8 feet below the crown. Flap gate located on the waterside (WS) end. Concrete headwall located on the landside (LS) end. Concrete "U" headwall located on the WS end. [Additional Reference(s): DWR Levee Log, 2002. USACE San Joaquin O&M Manuals: Unit No. 601, 1967, (HLM 0.07), Unit No. 601 Part I, 1967 (Amended in 1978), Unit No. 601 Part II, 1969, and Unit No. 601 Part III, 1969]
FS Date: 7/20/2016

Pipe, headwall, and flapgate at WS toe. Soil buildup partially blocking flapgate.

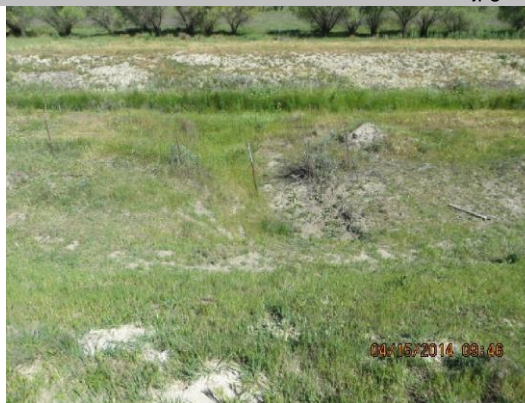
Photo 3 of 3 : UCIP_SP_2017_49966_60953.jpg

Pipe and headwall at LS toe.

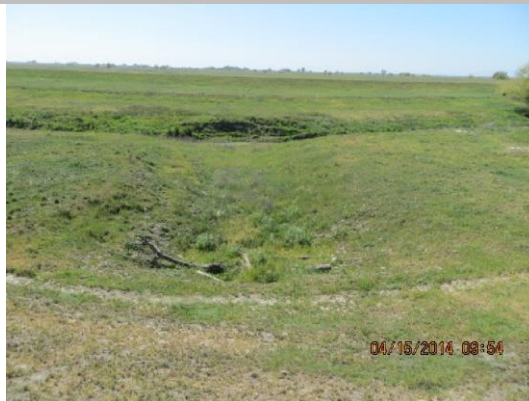
Photo 1 of 3 : UCIP_SP_2017_33712_60958.jpg

Pipe and headwall on WS toe.

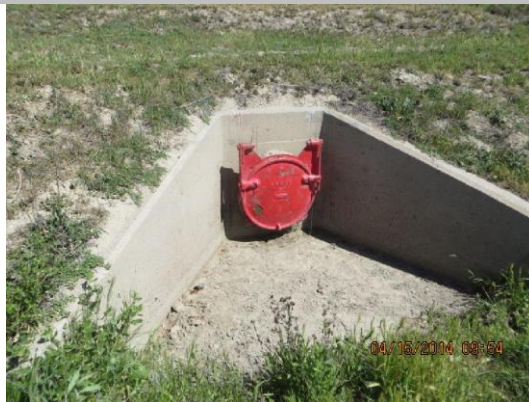
Photo 2 of 3 : UCIP_SP_2017_33712_60957.jpg

Pipe, headwall, and flapgate on WS toe.

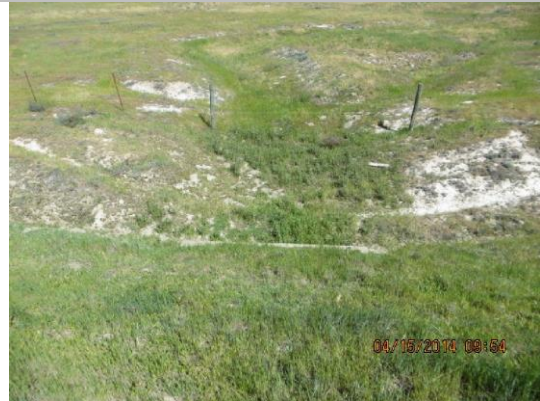
Photo 3 of 3 : UCIP_SP_2017_33712_60959.jpg

Pipe and headwall on LS toe.

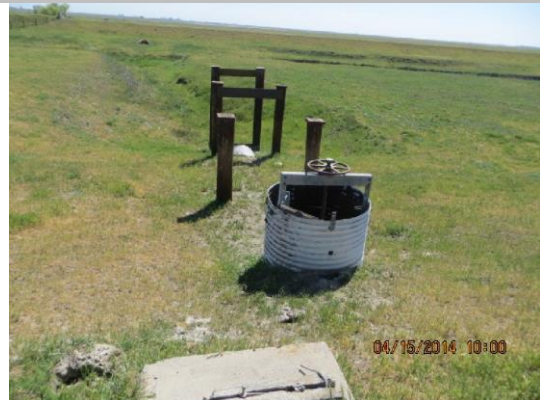
Photo 1 of 3 : UCIP_SP_2017_33713_60963.jpg

Comment Code					
Inspector Comment					
FS_ID:33713					
DS_ID:19894					
EP_NO: N/A					
Repair Type: Non-Urgent					
Crossing Status: Found					
UCIP Comments: Slide gate not operable, but left in closed position.					
Need to reinstall covers over slide gate standpipe.					
FIELD_STRUCT_DESC: 36-inch C.M stormdrain pipe through the					
levee, 9.7 feet below the crown. Slide gate in 48-inch C.M. pipe riser in					
the landward slope. Concrete "U" headwall on the landward end, inlet					
channel cobble revetted. Dilapidated wooden pier on WS. Waterward					
slope and outlet ditch cobble revetted. (USACE-1967). This entry					
matches the Drainage or Irrigation Structure referenced in O&M manual					
(HLM 0.49).					
FS Date: 4/15/2014

Slide gate in CMP riser on WS slope.

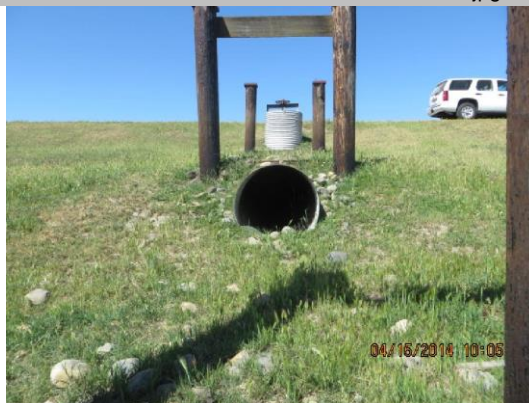
Photo 2 of 3 : UCIP_SP_2017_33713_60965.jpg

Outlet on WS slope.

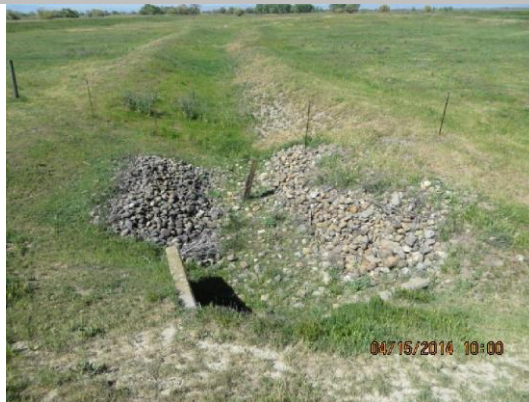
Photo 3 of 3 : UCIP_SP_2017_33713_60964.jpg

Pipe and headwall on LS toe.

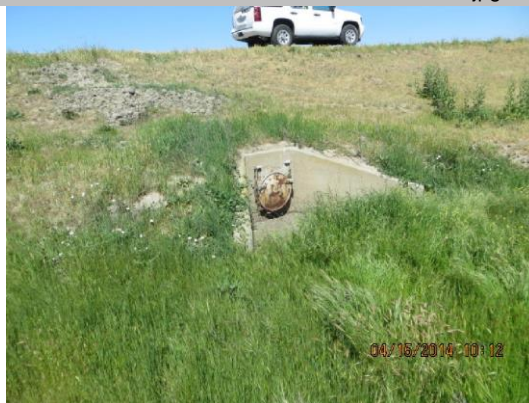
Photo 2 of 3 : UCIP_SP_2017_33723_60983.jpg

Flapgate on concrete headwall at WS toe.

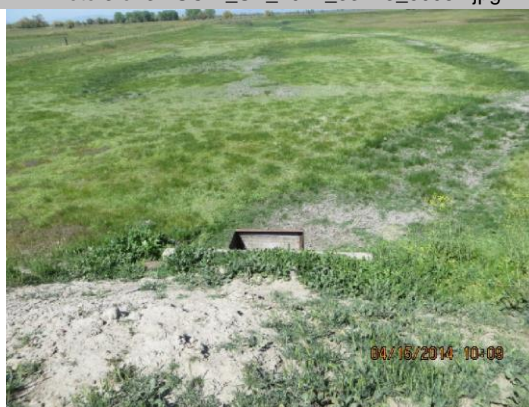
Photo 3 of 3 : UCIP_SP_2017_33723_60982.jpg

LM Start	0.53	Rating **	A/W	Issue No.	33 (cont)
LM End	0.53	Issue Type +	Ma	Location *	LS
Category	Supplemental			GPS Latitude/Longitude	
				Start	End
Item	DWR UCIP LMA Responsibility			37.259163 °	37.259163 °
				-120.764860 °	-120.764860 °
DWR ID					
Comment Code					
Inspector Comment					
FS_ID:33723 DS_ID:19895 EP_NO: N/A Repair Type: No Action Needed Crossing Status: Found UCIP Comments: FIELD_STRUCT_DESC: 24-inch C.M. stormdrain pipe through the levee, 9-feet below the crown. Flap gate on the waterward end. Concrete headwall with a wooden wier at inlet on LS toe. Concrete "U"-shaped headwall on the WS toe (USACE-1967). This entry matches the Drainage or Irrigation Structure referenced in O&M manual (HLM 0.53). FS Date: 4/15/2014

Headwall, pipe, and wier on LS toe.

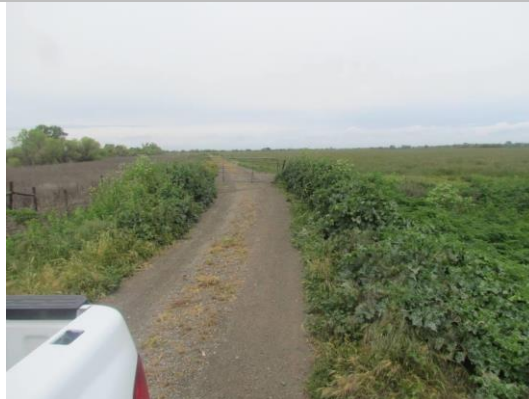
Photo 1 of 1 : SP_2017_NA0010_125_16_20170425_00039.jpg

LM Start	0.55	Rating **	U	Issue No.	16
LM End	1.16	Issue Type +	Ma	Location *	LS
Category	Earthen Levee			GPS Latitude/Longitude	
				Start	End
Item	Vegetation			37.259460 °	37.264452 °
				-120.764748 °	-120.756797 °
DWR ID	DWR_NA0010_07_s_2017_16				
Comment Code					
V1 : Control annual grass and weeds on the levee slopes and easements.					
Inspector Comment

Looking upstream at dense veg. on landward slope.

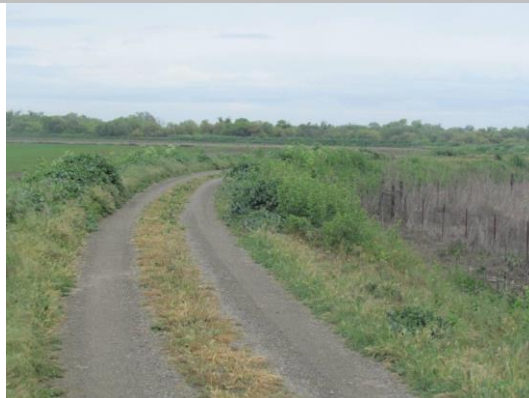
Photo 1 of 1 : SP_2017_NA0010_125_17_20170425_00040.jpg

LM Start	0.55	Rating **	U	Issue No.	17
LM End	1.16	Issue Type +	Ma	Location *	WS
Category	Earthen Levee			GPS Latitude/Longitude	
				Start	End
Item	Vegetation			37.259460 °	37.264452 °
				-120.764748 °	-120.756793 °
DWR ID	DWR_NA0010_07_s_2017_17				
Comment Code					
V1 : Control annual grass and weeds on the levee slopes and easements.					
Inspector Comment

Looking downstream at dense veg on waterward slope.
