**Flood Control Project Maintenance
Levee Inspections**

Maintenance Issue Types Only, Levee Inspection Report By Mile - Spring 2017

Lower San Joaquin Levee District

Waterway	Bank	Unit Miles	Inspection Start/End	Inspector
Unit No. 01 San Joaquin River	Right	22.52	04/17/2017 04/20/2017	Richard Willoughby

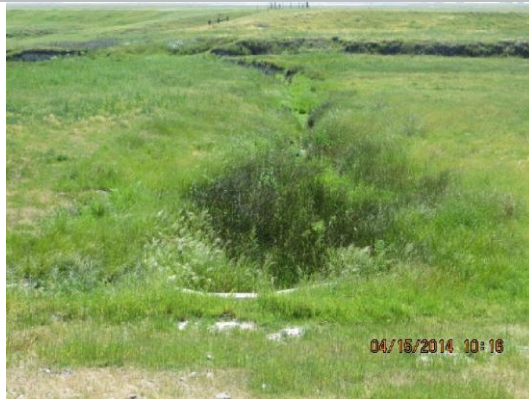
Photo 1 of 3 : UCIP_SP_2017_39507_60986.jpg

FS_ID:39507
DS_ID:19896
EP_NO: N/A
Repair Type: Non-Urgent
Crossing Status: Found
UCIP Comments: Need to contact owner. Heavy sediment buildup at inlet due to animal activity should be cleared.
FIELD_STRUCT_DESC: 24-inch C.M. stormdrain pipe through the levee, 9.8-feet below the crown. Flap gate on the waterward end. Wooden weir on concrete headwall at the LS toe. 36-inch concrete riser at LS toe. Concrete "U" headwall on the waterward end. Concrete standpipe on landward side. (USACE-1967). This entry matches the Drainage or Irrigation Structure referenced in O&M manual (HLM 0.85).
FS Date: 4/15/2014

Headwall and flapgate on WS toe.

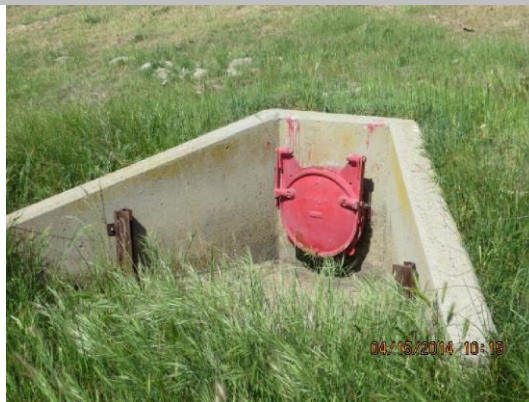
Photo 2 of 3 : UCIP_SP_2017_39507_60988.jpg

Headwall and flapgate on WS toe.

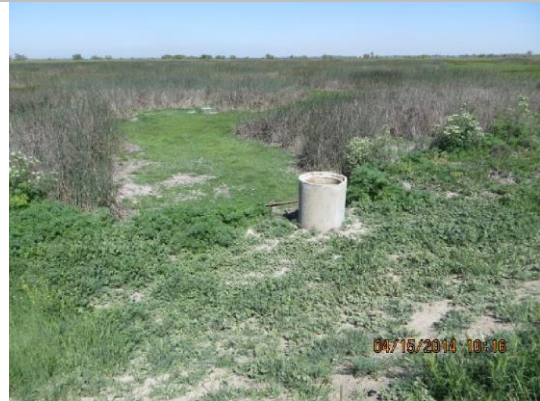
Photo 3 of 3 : UCIP_SP_2017_39507_60987.jpg

Comment Code					
Inspector Comment					
FS_ID:39507 DS_ID:19896 EP_NO: N/A Repair Type: Non-Urgent Crossing Status: Found UCIP Comments: Need to contact owner. Heavy sediment buildup at inlet due to animal activity should be cleared. FIELD_STRUCT_DESC: 24-inch C.M. stormdrain pipe through the levee, 9.8-feet below the crown. Flap gate on the waterward end. Wooden weir on concrete headwall at the LS toe. 36-inch concrete riser at LS toe. Concrete "U" headwall on the waterward end. Concrete standpipe on landward side. (USACE-1967). This entry matches the Drainage or Irrigation Structure referenced in O&M manual (HLM 0.85). FS Date: 4/15/2014

Concrete riser, concrete headwall, weir, and pipe at LS toe.

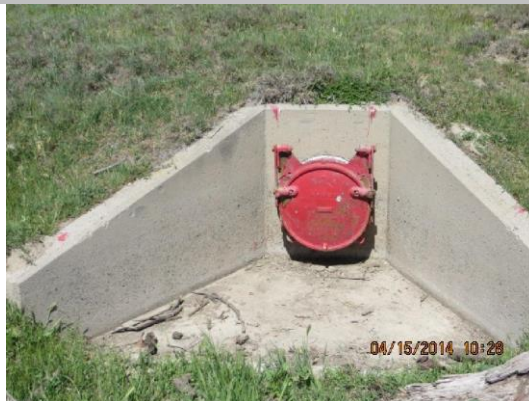
Photo 2 of 3 : UCIP_SP_2017_33725_60993.jpg

Concrete headwall and flapgate at WS toe.

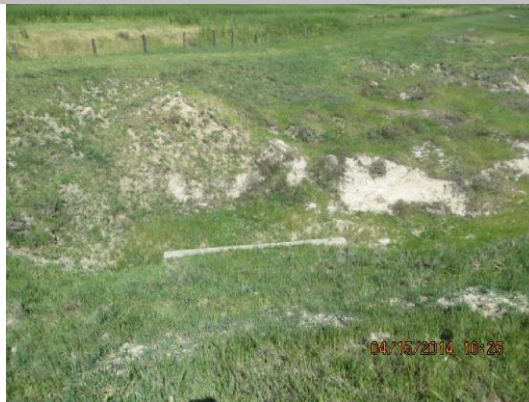
Photo 3 of 3 : UCIP_SP_2017_33725_60992.jpg

Concrete headwall and pipe on LS toe.

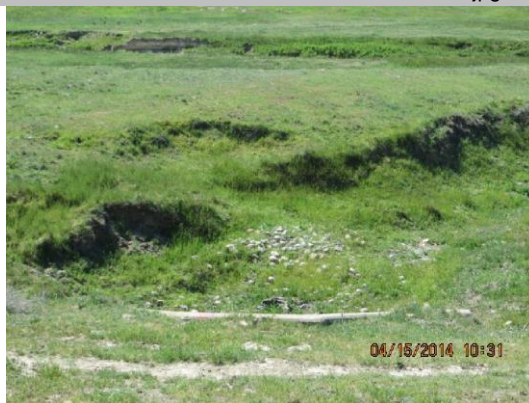
Photo 1 of 3 : UCIP_SP_2017_33726_60996.jpg

Pipe, flapgate, and headwall on WS toe.

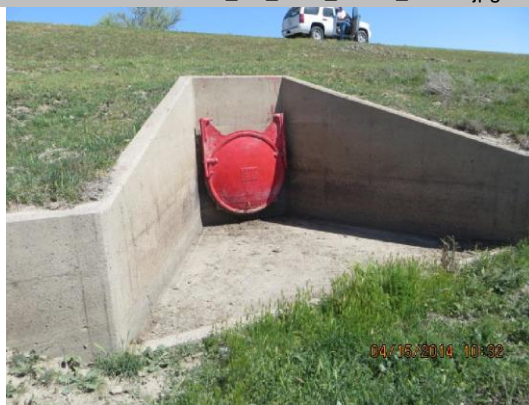
Photo 2 of 3 : UCIP_SP_2017_33726_60995.jpg

Flapgate at headwall on WS toe.

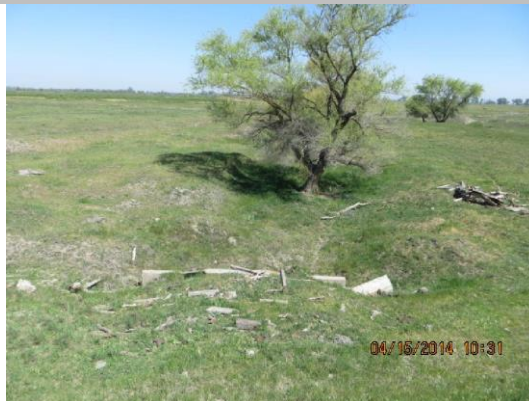
Photo 3 of 3 : UCIP_SP_2017_33726_60997.jpg

Pipe and headwall on LS toe.

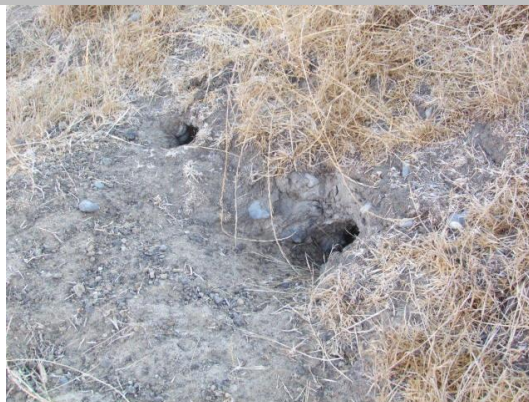
Photo 1 of 2 : SP_2017_NA0010_125_1_20170417_00001.jpg

LM Start	1.22	Rating **	M	Issue No.	1
LM End	1.22	Issue Type +	Ma	Location *	LS
Category	Earthen Levee			GPS Latitude/Longitude	
				Start	End
Item	Animal Control			37.264387 °	37.264387 °
				-120.755805 °	-120.755805 °
DWR ID	DWR_NA0010_07_f_2012_1				
Comment Code					
A1 : Exterminate rodents and backfill and compact or grout burrows.					
Inspector Comment

Looking north at several rodent holes on landward slope.

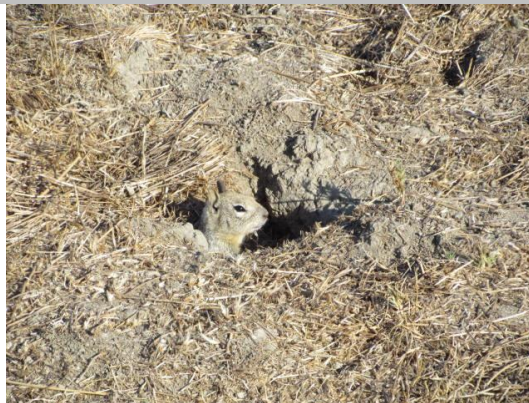
Photo 2 of 2 : SP_2017_NA0010_125_1_20170417_00002.jpg

LM Start	1.22	Rating **	M	Issue No.	1 (cont)	
LM End	1.22	Issue Type +	Ma	Location *	LS	
Category	Earthen Levee			GPS Latitude/Longitude		
				Start		End
Item	Animal Control			37.264387 °		37.264387 °
				-120.755805 °		-120.755805 °
DWR ID	DWR_NA0010_07_f_2012_1					
Comment Code						
A1 : Exterminate rodents and backfill and compact or grout burrows.						
Inspector Comment

Looking at east at active rodent holes on landside berm.

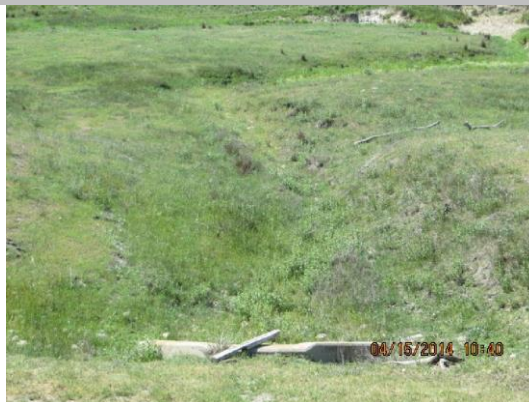
Photo 1 of 3 : UCIP_SP_2017_33727_61001.jpg

Pipe, headwall and flapgate on WS toe.

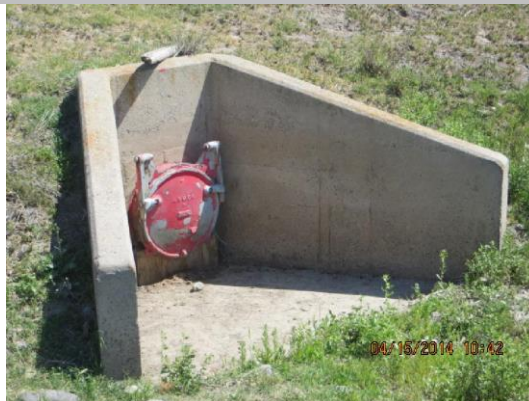
Photo 2 of 3 : UCIP_SP_2017_33727_61003.jpg

Pipe, headwall and flapgate on WS toe.

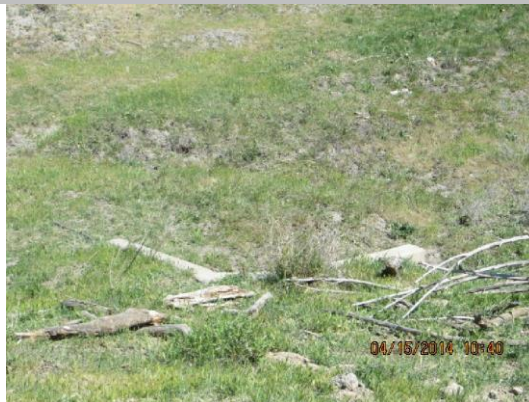
Photo 3 of 3 : UCIP_SP_2017_33727_61002.jpg

Headwall and pipe on LS toe.

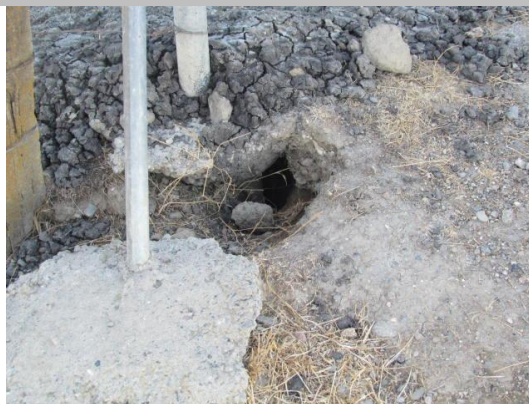
Photo 1 of 2 : SP_2017_NA0010_125_12_20170417_00003.jpg

LM Start	2.09	Rating **	M	Issue No.	12
LM End	2.09	Issue Type +	Ma	Location *	LS
Category	Earthen Levee		GPS Latitude/Longitude		
			Start	End	
Item	Animal Control		37.259187 °	37.259187 °	
			-120.742551 °	-120.742551 °	
DWR ID	DWR_NA0010_07_f _ 2014_12				
Comment Code					
A3 : No rodents visible, but rodent burrows visible; need to backfill and compact or grout burrows.					
Inspector Comment					
Rodent activity noted next to fence post.

Looking east at rodent hole next to fence post on landward shoulder.

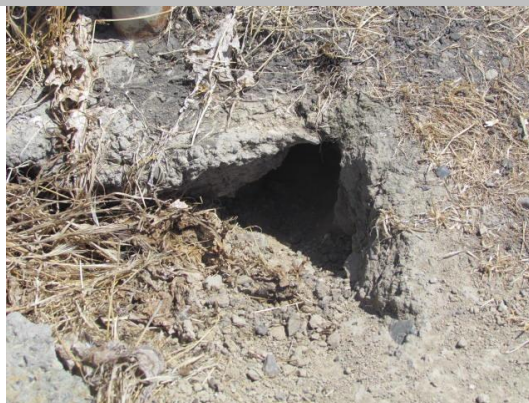
Photo 2 of 2 : SP_2017_NA0010_125_12_20170417_00004.jpg

LM Start	2.09	Rating **	M	Issue No.	12 (cont)
LM End	2.09	Issue Type +	Ma	Location *	LS
Category	Earthen Levee			GPS Latitude/Longitude	
				Start	End
Item	Animal Control			37.259187 °	37.259187 °
				-120.742551 °	-120.742551 °
DWR ID	DWR_NA0010_07_f_2014_12				
Comment Code					
A3 : No rodents visible, but rodent burrows visible; need to backfill and compact or grout burrows.					
Inspector Comment					
Rodent activity noted next to fence post.

Looking at rodent activity next to fence post

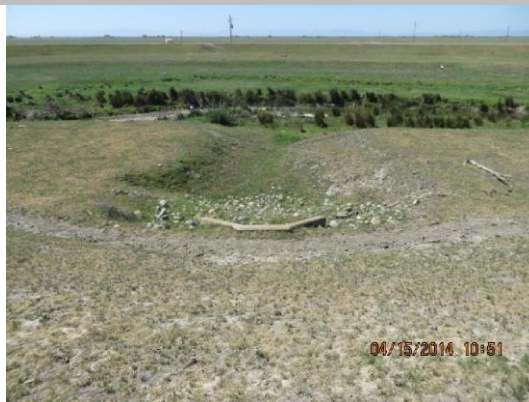
Photo 1 of 3 : UCIP_SP_2017_33728_61006.jpg

Headwall and flapgate on WS toe.

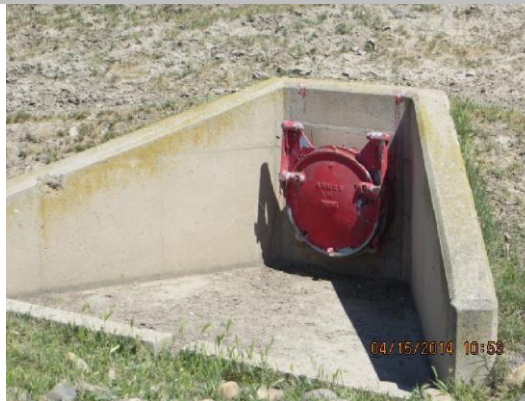
Photo 2 of 3 : UCIP_SP_2017_33728_61008.jpg

Concrete headwall and flapgate at WS toe.

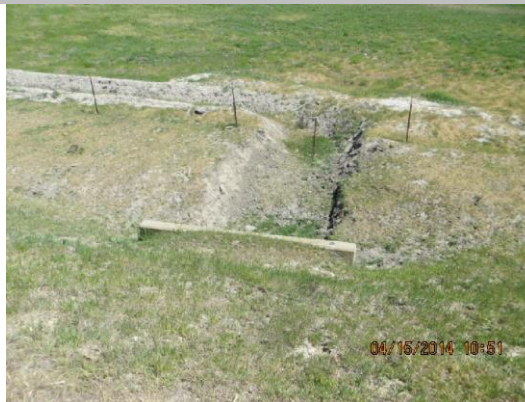
Photo 3 of 3 : UCIP_SP_2017_33728_61007.jpg

Concrete headwall and pipe on LS toe.

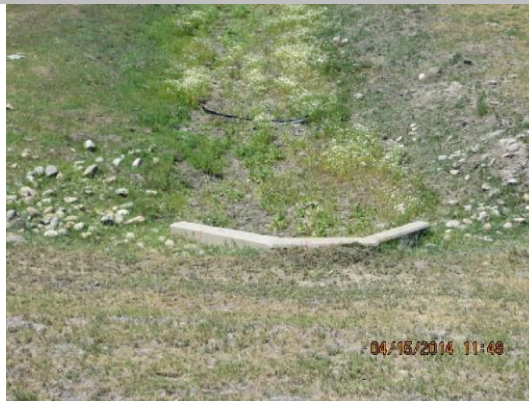
Photo 1 of 3 : UCIP_SP_2017_33729_61011.jpg

Concrete headwall and flapgate on WS toe.

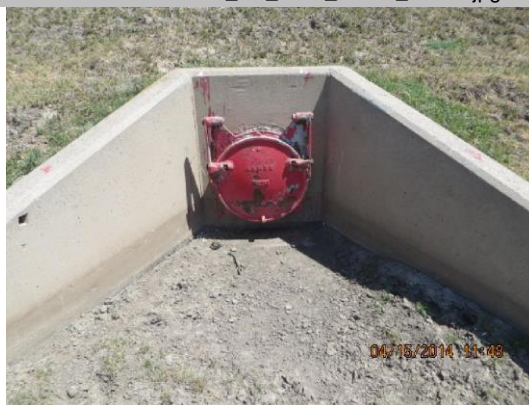
Photo 2 of 3 : UCIP_SP_2017_33729_61010.jpg

Concrete headwall and flapgate on WS toe.

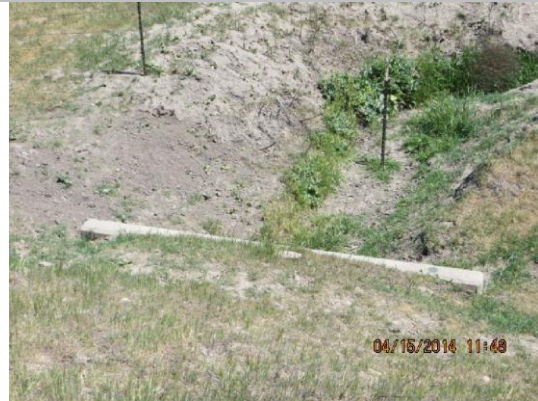
Photo 3 of 3 : UCIP_SP_2017_33729_61012.jpg

Concrete headwall and pipe at LS toe.

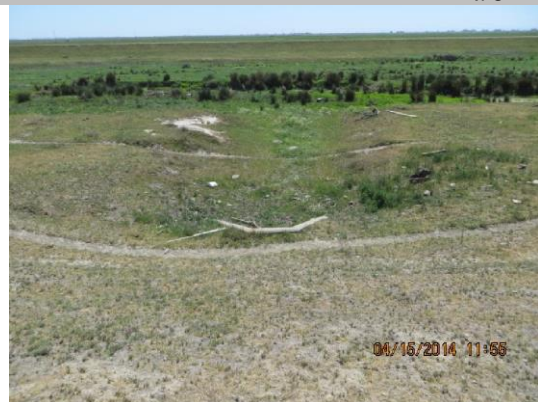
Photo 1 of 3 : UCIP_SP_2017_39508_61016.jpg

LM Start	3.09	Rating **	M	Issue No.	40
LM End	3.09	Issue Type +	Ma	Location *	LS
Category	Supplemental			GPS Latitude/Longitude	
				Start	End
Item	DWR UCIP LMA Responsibility			37.251883 °	37.251883 °
				-120.728264 °	-120.728264 °
DWR ID					
Comment Code					
Inspector Comment					
FS_ID:39508					
DS_ID:19901					
EP_NO: N/A					
Repair Type: Non-Urgent					
Crossing Status: Found					
UCIP Comments: Some sediment buildup at landward toe and inside pipe--recommend clearing.					
FIELD_STRUCT_DESC: 24-inch C.M. stormdrain pipe through the levee, 10.4-feet below the crown. Flap gate on the waterward end. Concrete headwall on the landward end. Concrete "U" headwall on the waterward end. (USACE-1967). This entry matches the Drainage or Irrigation Structure referenced in O&M manual (HLM 3.09).					
FS Date: 4/15/2014

Headwall, pipe, and flapgate on WS toe.

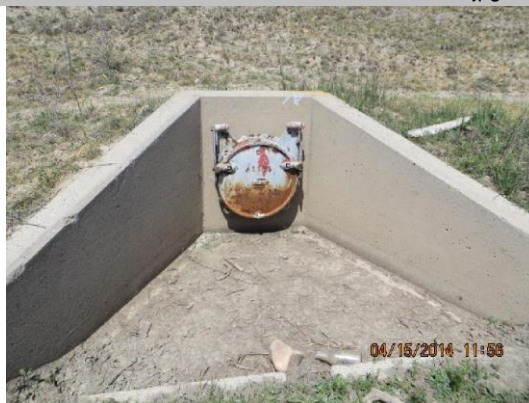
Photo 2 of 3 : UCIP_SP_2017_39508_61015.jpg

LM Start	3.09	Rating **	M	Issue No.	40 (cont)	
LM End	3.09	Issue Type +	Ma	Location *	LS	
Category	Supplemental			GPS Latitude/Longitude		
				Start		End
Item	DWR UCIP LMA Responsibility			37.251883 °		37.251883 °
				-120.728264 °		-120.728264 °
DWR ID						
Comment Code						
Inspector Comment						
FS_ID:39508						
DS_ID:19901						
EP_NO: N/A						
Repair Type: Non-Urgent						
Crossing Status: Found						
UCIP Comments: Some sediment buildup at landward toe and inside pipe--recommend clearing.						
FIELD_STRUCT_DESC: 24-inch C.M. stormdrain pipe through the levee, 10.4-feet below the crown. Flap gate on the waterward end. Concrete headwall on the landward end. Concrete "U" headwall on the waterward end. (USACE-1967). This entry matches the Drainage or Irrigation Structure referenced in O&M manual (HLM 3.09).						
FS Date: 4/15/2014

Headwall, pipe, and flapgate on WS toe.

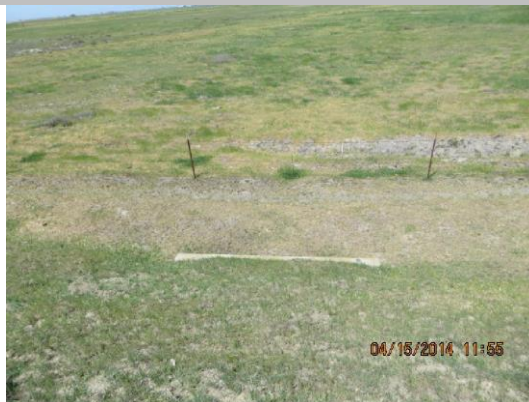
Photo 3 of 3 : UCIP_SP_2017_39508_61017.jpg

Headwall and pipe on LS toe.

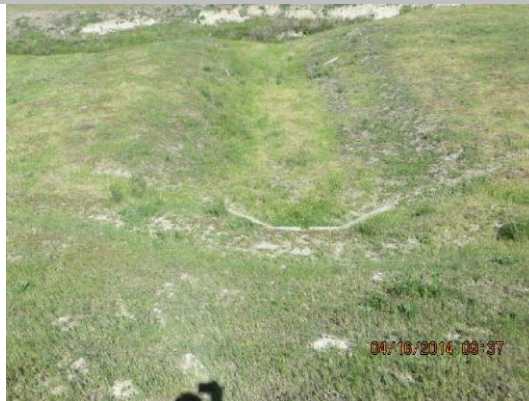
Photo 1 of 3 : UCIP_SP_2017_33751_61068.jpg

LM Start	0.23	Rating **	A/W	Issue No.	22
LM End	0.23	Issue Type +	Ma	Location *	WS
Category	Supplemental			GPS Latitude/Longitude	
				Start	End
Item	DWR UCIP LMA Responsibility			37.256092 °	37.256092 °
				-120.767873 °	-120.767873 °
DWR ID					
Comment Code					
Inspector Comment					
FS_ID:33751 DS_ID:19903 EP_NO: N/A Repair Type: No Action Needed Crossing Status: Found UCIP Comments: FIELD_STRUCT_DESC: 24-inch CM stormdrain pipe through levee, 9.6- feet below crown. Flap gate on the waterward end. Concrete headwall on the landward end. Concrete "U" headwall on the waterward end. (USACE-1967). This entry matches the Drainage or Irrigation Structure referenced in O&M manual (HLM 0.23). FS Date: 4/16/2014

Headwall and flapgate on WS toe.

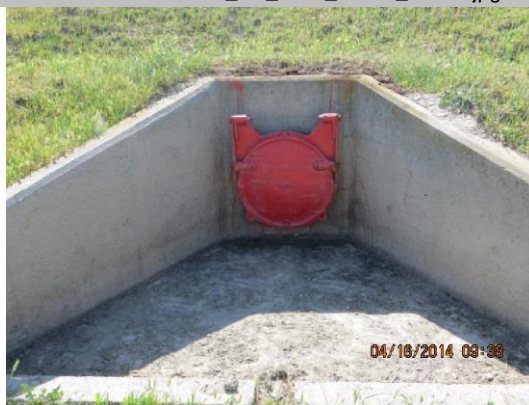
Photo 2 of 3 : UCIP_SP_2017_33751_61067.jpg

Headwall and flapgate on WS toe.

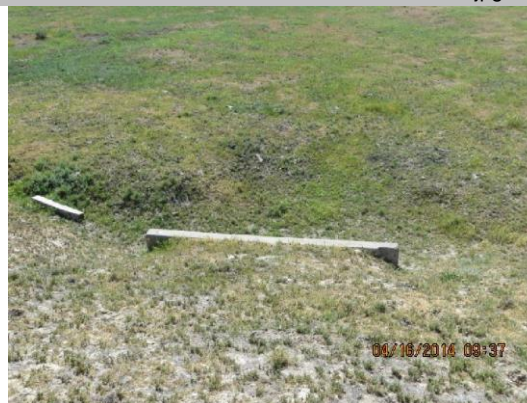
Photo 3 of 3 : UCIP_SP_2017_33751_61069.jpg

LM Start	0.23	Rating **	A/W	Issue No.	22 (cont)	
LM End	0.23	Issue Type +	Ma	Location *	WS	
Category	Supplemental			GPS Latitude/Longitude		
				Start		End
Item	DWR UCIP LMA Responsibility			37.256092 °		37.256092 °
				-120.767873 °		-120.767873 °
DWR ID						
Comment Code						
Inspector Comment						
FS_ID:33751						
DS_ID:19903						
EP_NO: N/A						
Repair Type: No Action Needed						
Crossing Status: Found						
UCIP Comments:						
FIELD_STRUCT_DESC: 24-inch CM stormdrain pipe through levee, 9.6-						
feet below crown. Flap gate on the waterward end. Concrete headwall						
on the landward end. Concrete "U" headwall on the waterward end.						
(USACE-1967). This entry matches the Drainage or Irrigation Structure						
referenced in O&M manual (HLM 0.23).						
FS Date: 4/16/2014

Concrete headwall on LS toe.

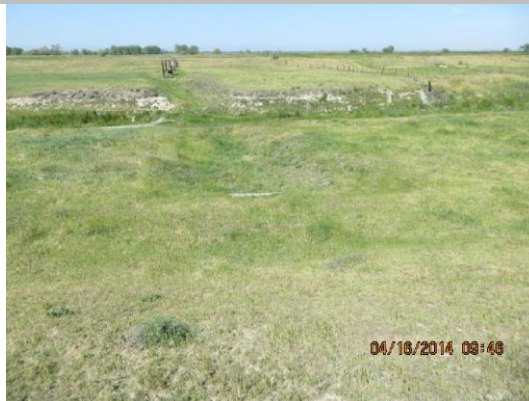
Photo 1 of 3 : UCIP_SP_2017_33752_61073.jpg

LM Start	0.57	Rating **	A/W	Issue No.	23
LM End	0.57	Issue Type +	Ma	Location *	WS
Category	Supplemental			GPS Latitude/Longitude	
				Start	End
Item	DWR UCIP LMA Responsibility			37.258604 °	37.258604 °
				-120.763588 °	-120.763588 °
DWR ID					
Comment Code					
Inspector Comment					
FS_ID:33752 DS_ID:19904 EP_NO: N/A Repair Type: No Action Needed Crossing Status: Found UCIP Comments: FIELD_STRUCT_DESC: 24-inch CM stormdrain pipe through levee, 12.4-feet below crown. Flap gate on the waterward end. Concrete headwall on both ends. (USACE-1967). This entry matches the Drainage or Irrigation Structure referenced in O&M manual (HLM 0.57). FS Date: 4/16/2014

Pipe, flapgate and headwall on WS toe.

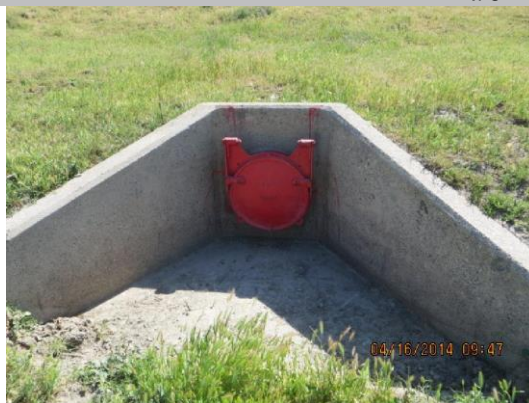
Photo 2 of 3 : UCIP_SP_2017_33752_61072.jpg

Pipe, flapgate and headwall on WS toe.

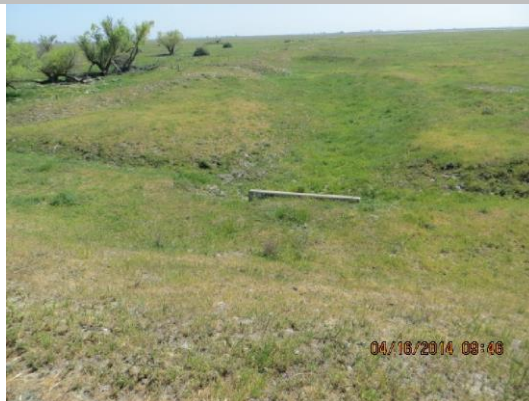
Photo 3 of 3 : UCIP_SP_2017_33752_61074.jpg

LM Start	0.57	Rating **	A/W	Issue No.	23 (cont)	
LM End	0.57	Issue Type +	Ma	Location *	WS	
Category	Supplemental			GPS Latitude/Longitude		
				Start	End	
Item	DWR UCIP LMA Responsibility			37.258604 °	37.258604 °	
				-120.763588 °	-120.763588 °	
DWR ID						
Comment Code						
Inspector Comment						
FS_ID:33752 DS_ID:19904 EP_NO: N/A Repair Type: No Action Needed Crossing Status: Found UCIP Comments: FIELD_STRUCT_DESC: 24-inch CM stormdrain pipe through levee, 12.4-feet below crown. Flap gate on the waterward end. Concrete headwall on both ends. (USACE-1967). This entry matches the Drainage or Irrigation Structure referenced in O&M manual (HLM 0.57). FS Date: 4/16/2014

Pipe and headwall on LS toe.

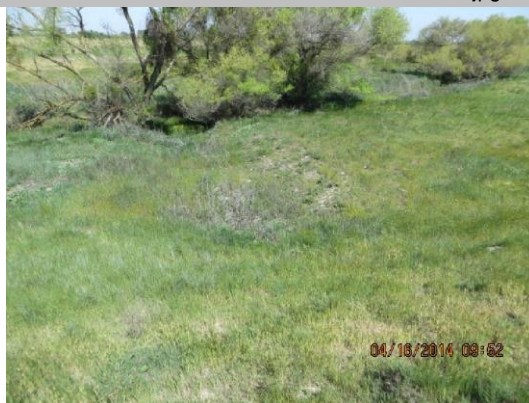
Photo 1 of 3 : UCIP_SP_2017_33753_61078.jpg

LM Start	0.72	Rating **	A/W	Issue No.	24
LM End	0.72	Issue Type +	Ma	Location *	WS
Category	Supplemental			GPS Latitude/Longitude	
				Start	End
Item	DWR UCIP LMA Responsibility			37.260306 °	37.260306 °
				-120.762127 °	-120.762127 °
DWR ID					
Comment Code					
Inspector Comment					
FS_ID:33753 DS_ID:19905 EP_NO: N/A Repair Type: No Action Needed Crossing Status: Found UCIP Comments: FIELD_STRUCT_DESC: 24-inch CM stormdrain pipe through levee, 10.0-feet below crown. Flap gate on the waterward end. Concrete headwall on both ends. (USACE-1967). This entry matches the Drainage or Irrigation Structure referenced in O&M manual (HLM 0.72). FS Date: 4/16/2014

Headwall and flapgate at WS toe.

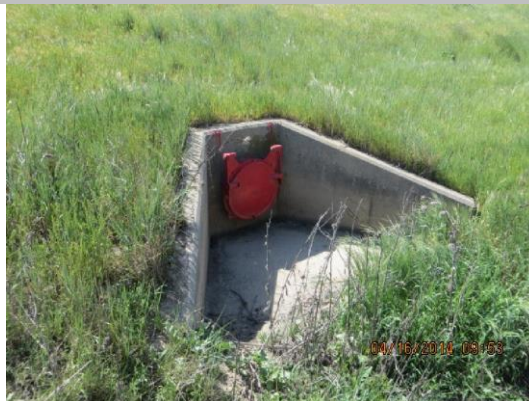
Photo 2 of 3 : UCIP_SP_2017_33753_61080.jpg

LM Start	0.72	Rating **	A/W	Issue No.	24 (cont)	
LM End	0.72	Issue Type +	Ma	Location *	WS	
Category	Supplemental			GPS Latitude/Longitude		
				Start	End	
Item	DWR UCIP LMA Responsibility			37.260306 °	37.260306 °	
				-120.762127 °	-120.762127 °	
DWR ID						
Comment Code						
Inspector Comment						
FS_ID:33753 DS_ID:19905 EP_NO: N/A Repair Type: No Action Needed Crossing Status: Found UCIP Comments: FIELD_STRUCT_DESC: 24-inch CM stormdrain pipe through levee, 10.0-feet below crown. Flap gate on the waterward end. Concrete headwall on both ends. (USACE-1967). This entry matches the Drainage or Irrigation Structure referenced in O&M manual (HLM 0.72). FS Date: 4/16/2014

Headwall and flapgate at WS toe.

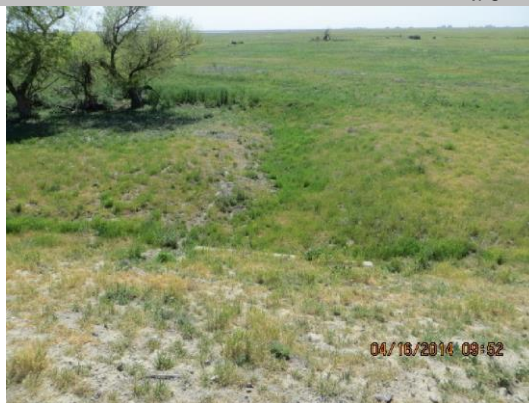
Photo 3 of 3 : UCIP_SP_2017_33753_61079.jpg

Concrete headwall on LS toe.

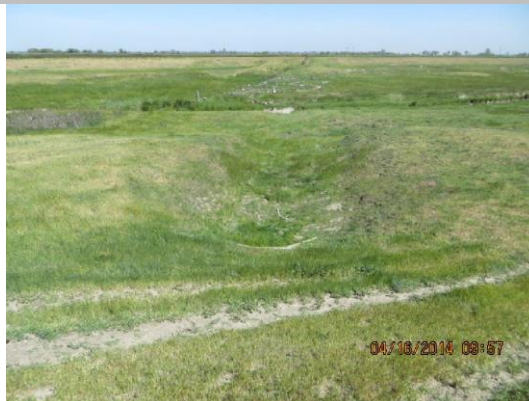
Photo 1 of 3 : UCIP_SP_2017_39887_61084.jpg

LM Start	0.90	Rating **	M	Issue No.	25
LM End	0.90	Issue Type +	Ma	Location *	WS
Category	Supplemental			GPS Latitude/Longitude	
				Start	End
Item	DWR UCIP LMA Responsibility			37.262384 °	37.262384 °
				-120.760528 °	-120.760528 °
DWR ID					
Comment Code					
Inspector Comment					
FS_ID:39887 DS_ID:19832 EP_NO: N/A Repair Type: Non-Urgent Crossing Status: Found UCIP Comments: Some sediment buildup at inlet on LS toe. FIELD_STRUCT_DESC: 24-inch CM stormdrain pipe through levee, 11.5 feet below crown. Flap gate on the waterward end. Concrete headwalls. (USACE-1967). This entry matches the Drainage or Irrigation Structure referenced in O&M manual (HLM 0.89). FS Date: 4/16/2014

Headwall, pipe, and flapgate on WS toe.

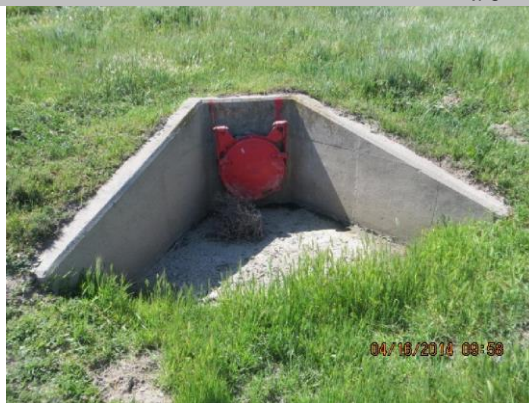
Photo 2 of 3 : UCIP_SP_2017_39887_61083.jpg

Headwall, pipe, and flapgate on WS toe.

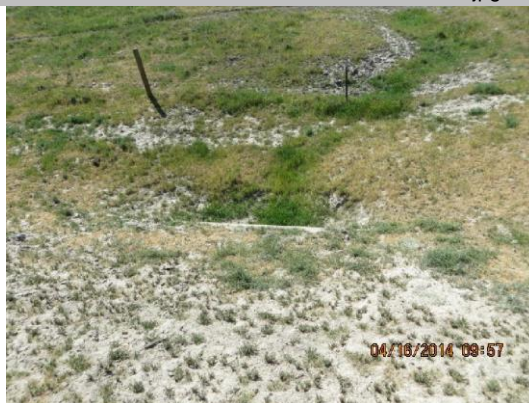
Photo 3 of 3 : UCIP_SP_2017_39887_61085.jpg

LM Start	0.90	Rating **	M	Issue No.	25 (cont)	
LM End	0.90	Issue Type +	Ma	Location *	WS	
Category	Supplemental			GPS Latitude/Longitude		
				Start	End	
Item	DWR UCIP LMA Responsibility			37.262384 °	37.262384 °	
				-120.760528 °	-120.760528 °	
DWR ID						
Comment Code						
Inspector Comment						
FS_ID:39887						
DS_ID:19832						
EP_NO: N/A						
Repair Type: Non-Urgent						
Crossing Status: Found						
UCIP Comments: Some sediment buildup at inlet on LS toe.						
FIELD_STRUCT_DESC: 24-inch CM stormdrain pipe through levee,						
11.5 feet below crown. Flap gate on the waterward end. Concrete						
headwalls. (USACE-1967). This entry matches the Drainage or						
Irrigation Structure referenced in O&M manual (HLM 0.89).						
FS Date: 4/16/2014

Pipe and headwall on LS toe.

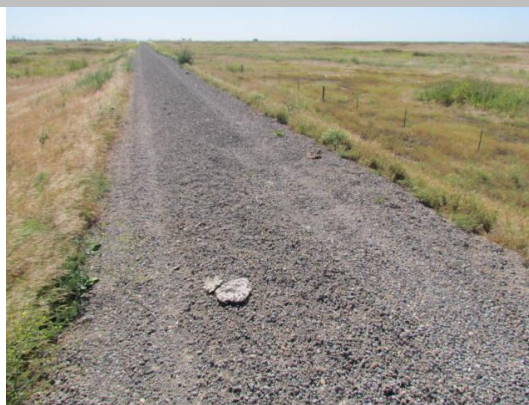
Photo 1 of 1 : SP_2017_NA0010_126_5_20170417_00002.jpg

LM Start	1.16	Rating **	M	Issue No.	5
LM End	3.58	Issue Type +	Ma	Location *	CR
Category	Earthen Levee			GPS Latitude/Longitude	
				Start	End
Item	Crown Surface / Depressions / Rutting			37.263243 °	37.253780 °
				-120.756372 °	-120.719503 °
DWR ID	DWR_NA0010_08_s_2016_5				
Comment Code					
C2 : Repair depressions or ruts in the crown or slope.					
Inspector Comment					
Depression noted on levee crown.

Looking west at depression on toward landward shoulder.

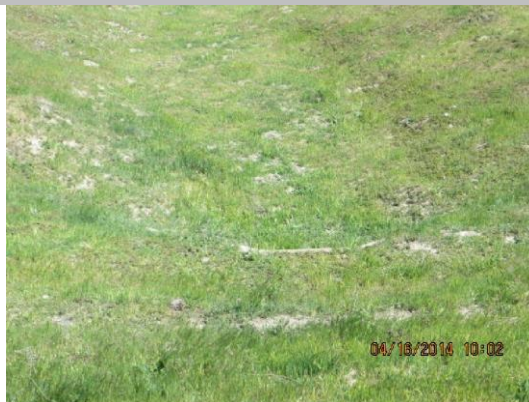
Photo 1 of 3 : UCIP_SP_2017_39509_61090.jpg

LM Start	1.21	Rating **	M	Issue No.	26
LM End	1.21	Issue Type +	Ma	Location *	LS
Category	Supplemental			GPS Latitude/Longitude	
				Start	End
Item	DWR UCIP LMA Responsibility			37.263188 °	37.263188 °
				-120.755399 °	-120.755399 °
DWR ID					
Comment Code					
Inspector Comment					
FS_ID:39509 DS_ID:19833 EP_NO: N/A Repair Type: Non-Urgent Crossing Status: Found UCIP Comments: Debris blocking landward headwall--recommend clearing. FIELD_STRUCT_DESC: 24-inch CM stormdrain pipe through levee, 11.6 feet below crown. Flap gate on the waterward end. Concrete headwalls. (USACE-1967). This entry matches the Drainage or Irrigation Structure referenced in O&M manual (HLM 1.21). FS Date: 4/16/2014

Concrete headwall, pipe, and flapgate on WS toe.

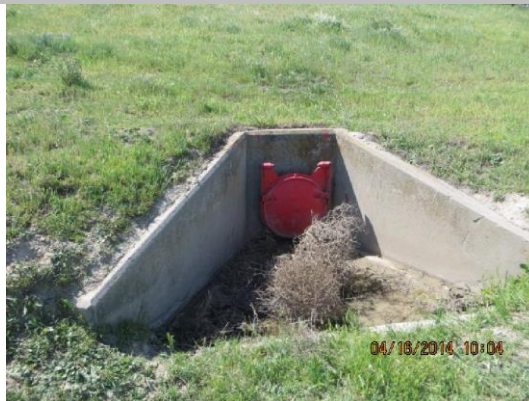
Photo 2 of 3 : UCIP_SP_2017_39509_61091.jpg

LM Start	1.21	Rating **	M	Issue No.	26 (cont)	
LM End	1.21	Issue Type +	Ma	Location *	LS	
Category	Supplemental			GPS Latitude/Longitude		
				Start		End
Item	DWR UCIP LMA Responsibility			37.263188 °		37.263188 °
				-120.755399 °		-120.755399 °
DWR ID						
Comment Code						
Inspector Comment						
FS_ID:39509 DS_ID:19833 EP_NO: N/A Repair Type: Non-Urgent Crossing Status: Found UCIP Comments: Debris blocking landward headwall--recommend clearing. FIELD_STRUCT_DESC: 24-inch CM stormdrain pipe through levee, 11.6 feet below crown. Flap gate on the waterward end. Concrete headwalls. (USACE-1967). This entry matches the Drainage or Irrigation Structure referenced in O&M manual (HLM 1.21). FS Date: 4/16/2014

Concrete headwall, pipe, and flapgate on WS toe.

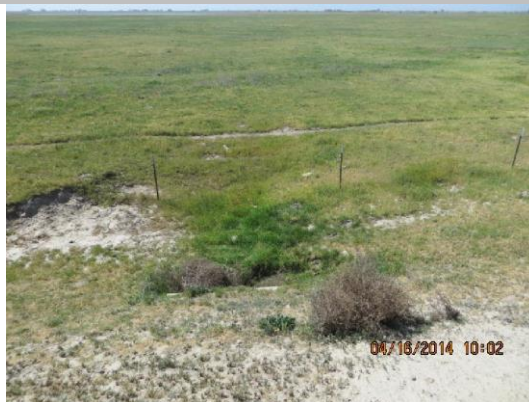
Photo 3 of 3 : UCIP_SP_2017_39509_61089.jpg

Pipe and headwall on LS toe.

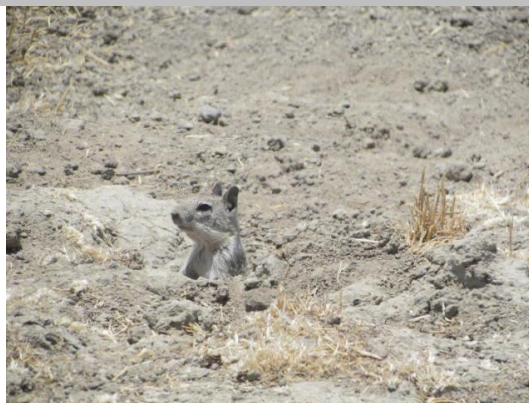
Photo 1 of 1 : SP_2017_NA0010_126_8_20170417_00004.jpg

LM Start	1.38	Rating **	M	Issue No.	8
LM End	1.38	Issue Type +	Ma	Location *	LS
Category	Earthen Levee			GPS Latitude/Longitude	
				Start	End
Item	Animal Control			37.263175 °	37.263175 °
				-120.752307 °	-120.752307 °
DWR ID	DWR_NA0010_08_s_2013_8				
Comment Code					
A1 : Exterminate rodents and backfill and compact or grout burrows.					
Inspector Comment

Looking west at rodent holes on landward slope.

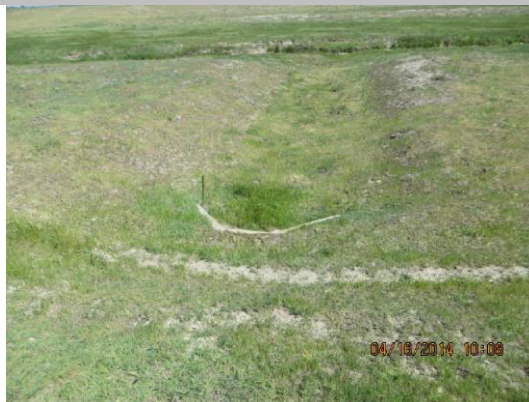
Photo 1 of 3 : UCIP_SP_2017_39510_61094.jpg

LM Start	1.38	Rating **	M	Issue No.	27
LM End	1.38	Issue Type +	Ma	Location *	LS
Category	Supplemental			GPS Latitude/Longitude	
				Start	End
Item	DWR UCIP LMA Responsibility			37.263194 °	37.263194 °
				-120.752299 °	-120.752299 °
DWR ID					
Comment Code					
Inspector Comment					
FS_ID:39510 DS_ID:19834 EP_NO: N/A Repair Type: Non-Urgent Crossing Status: Found UCIP Comments: Animal burrows along pipe alignment on LS. Some sediment buildup at LS toe and inside pipe--recommend clearing. FIELD_STRUCT_DESC: 24-inch CM stormdrain pipe through levee, 11.5 feet below crown. Flap gate on the waterward end. Concrete headwall on both ends. (USACE-1967). This entry matches the Drainage or Irrigation Structure referenced in O&M manual (HLM 1.38). FS Date: 4/16/2014

Pipe, headwall, and flapgate on WS toe.

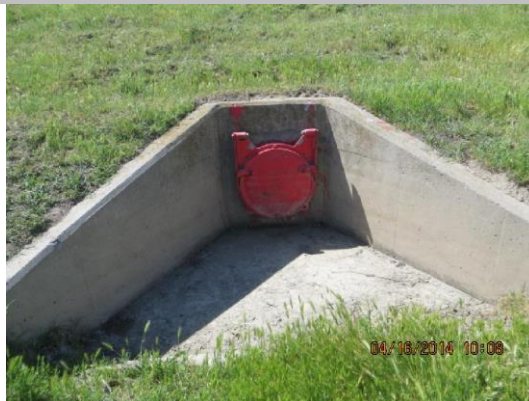
Photo 2 of 3 : UCIP_SP_2017_39510_61093.jpg

LM Start	1.38	Rating **	M	Issue No.	27 (cont)	
LM End	1.38	Issue Type +	Ma	Location *	LS	
Category	Supplemental			GPS Latitude/Longitude		
				Start	End	
Item	DWR UCIP LMA Responsibility			37.263194 °	37.263194 °	
				-120.752299 °	-120.752299 °	
DWR ID						
Comment Code						
Inspector Comment						
FS_ID:39510 DS_ID:19834 EP_NO: N/A Repair Type: Non-Urgent Crossing Status: Found UCIP Comments: Animal burrows along pipe alignment on LS. Some sediment buildup at LS toe and inside pipe--recommend clearing. FIELD_STRUCT_DESC: 24-inch CM stormdrain pipe through levee, 11.5 feet below crown. Flap gate on the waterward end. Concrete headwall on both ends. (USACE-1967). This entry matches the Drainage or Irrigation Structure referenced in O&M manual (HLM 1.38). FS Date: 4/16/2014

Pipe, headwall, and flapgate on WS toe.

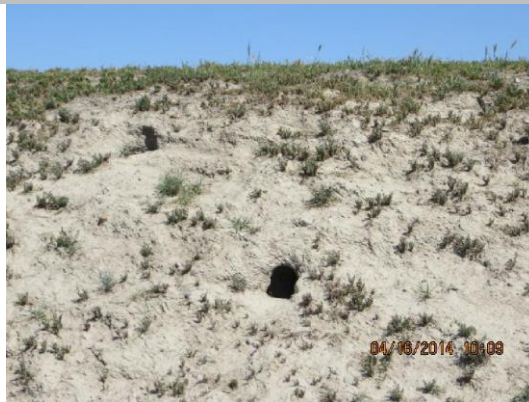
Photo 3 of 3 : UCIP_SP_2017_39510_61095.jpg

Animal burrows along alignment on LS slope.

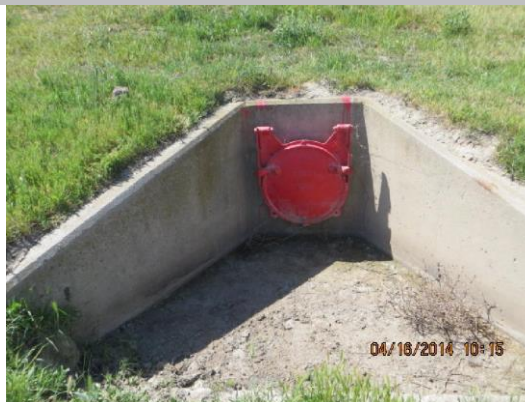
Photo 1 of 3 : UCIP_SP_2017_39511_61098.jpg

LM Start	2.05	Rating **	M	Issue No.	28
LM End	2.05	Issue Type +	Ma	Location *	WS
Category	Supplemental			GPS Latitude/Longitude	
				Start	End
Item	DWR UCIP LMA Responsibility			37.258220 °	37.258220 °
				-120.742868 °	-120.742868 °
DWR ID					
Comment Code					
Inspector Comment					
FS_ID:39511 DS_ID:19835 EP_NO: N/A Repair Type: Non-Urgent Crossing Status: Found UCIP Comments: Non-functional landward inlet is buried in sediment. Need to contact owner to determine status. FIELD_STRUCT_DESC: 24-inch CM stormdrain pipe through levee, 12.0 feet below crown. Flap gate on the waterward end. Concrete headwall on both ends. (USACE-1967). This entry matches the Drainage or Irrigation Structure referenced in O&M manual (HLM 2.05). FS Date: 4/16/2014

Pipe, headwall, and flapgate on Ws toe.

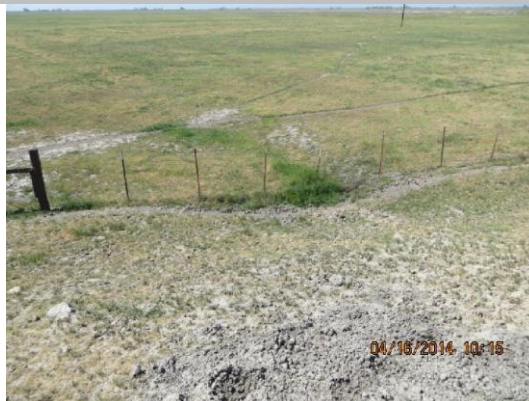
Photo 2 of 3 : UCIP_SP_2017_39511_61099.jpg

Pipe and headwall buried in sediment at LS toe.

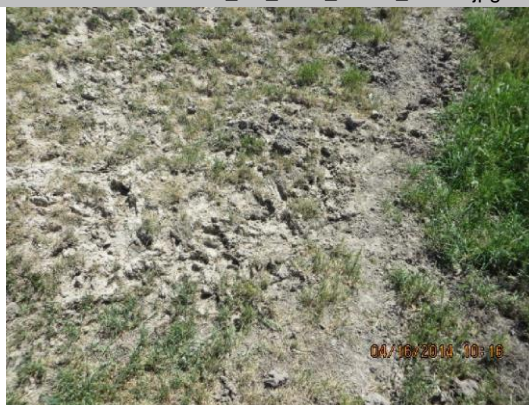
Photo 3 of 3 : UCIP_SP_2017_39511_61097.jpg

Pipe and headwall buried in sediment at LS toe.

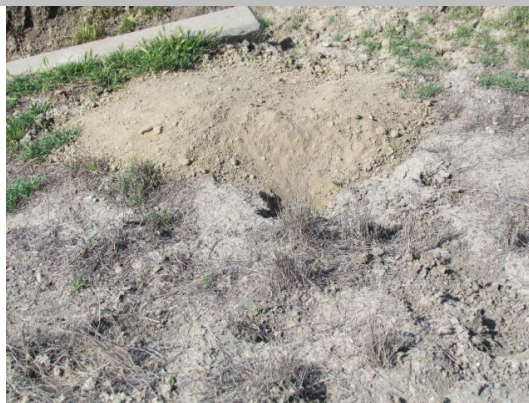
Photo 1 of 1 : SP_2017_NA0010_126_7_20170417_00003.jpg

LM Start	2.07	Rating **	M	Issue No.	7
LM End	2.13	Issue Type +	Ma	Location *	LS
Category	Earthen Levee			GPS Latitude/Longitude	
				Start	End
Item	Animal Control			37.258063 °	37.257688 °
				-120.742460 °	-120.741573 °
DWR ID	DWR_NA0010_08_s_2012_7				
Comment Code					
A1 : Exterminate rodents and backfill and compact or grout burrows.					
Inspector Comment					
No rodent activity and no rodent holes noted.

Looking at typical rodent hole on landside slope near headwall.

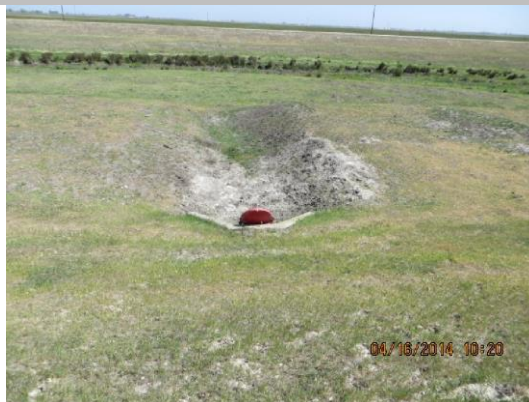
Photo 1 of 3 : UCIP_SP_2017_39512_61102.jpg

LM Start	2.12	Rating **	M	Issue No.	29
LM End	2.12	Issue Type +	Ma	Location *	LS
Category	Supplemental			GPS Latitude/Longitude	
				Start	End
Item	DWR UCIP LMA Responsibility			37.257800 °	37.257800 °
				-120.741604 °	-120.741604 °
DWR ID					
Comment Code					
Inspector Comment					
FS_ID:39512					
DS_ID:19836					
EP_NO: N/A					
Repair Type: Non-Urgent					
Crossing Status: Found					
UCIP Comments: Sediment buildup in pipe visible from landward side.					
FIELD_STRUCT_DESC: 24-inch CM stormdrain pipe through levee, 9.5-					
feet below crown. Flap gate on the waterward end. Concrete headwall					
on both ends. (USACE-1967). This entry matches the Drainage or					
Irrigation Structure referenced in O&M manual (HLM 2.12).					
FS Date: 4/16/2014

Pipe, headwall, and flapgate on WS toe.

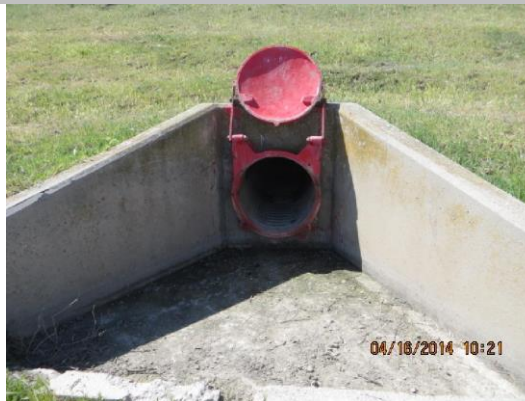
Photo 2 of 3 : UCIP_SP_2017_39512_61100.jpg

Pipe, headwall, and flapgate on WS toe.

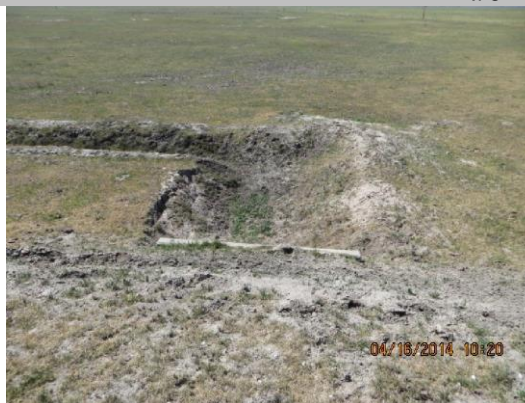
Photo 3 of 3 : UCIP_SP_2017_39512_61101.jpg

Pipe and headwall on LS toe.

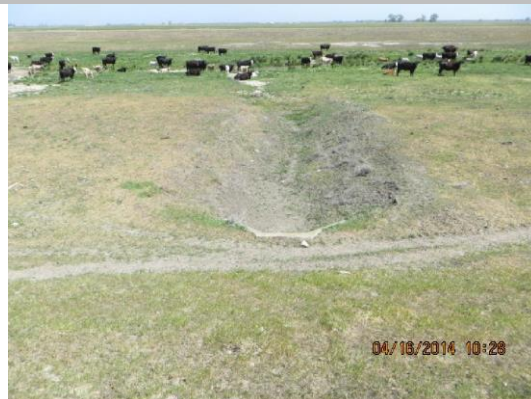
Photo 1 of 3 : UCIP_SP_2017_33760_61107.jpg

FS_ID:33760
 DS_ID:19837
 EP_NO: N/A
 Repair Type: No Action Needed
 Crossing Status: Found
 UCIP Comments:
 FIELD_STRUCT_DESC: 24-inch CM stormdrain pipe through levee, 10.5 feet below crown. Flap gate on the waterward end. Concrete headwall on both ends. (USACE-1967). This entry matches the Drainage or Irrigation Structure referenced in O&M manual (HLM 2.77).
 FS Date: 4/16/2014

Pipe, headwall, and flapgate on Ws toe.

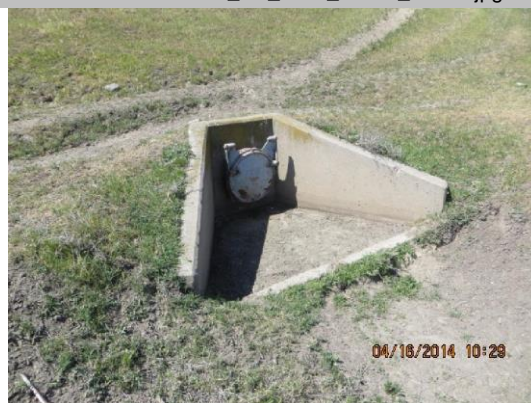
Photo 2 of 3 : UCIP_SP_2017_33760_61105.jpg

Pipe, headwall, and flapgate on Ws toe.

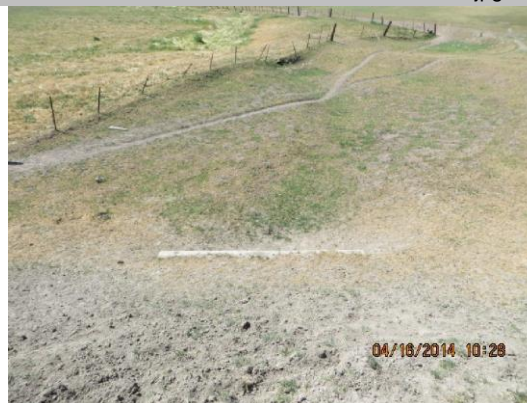
Photo 3 of 3 : UCIP_SP_2017_33760_61106.jpg

Pipe and headwall on LS toe.

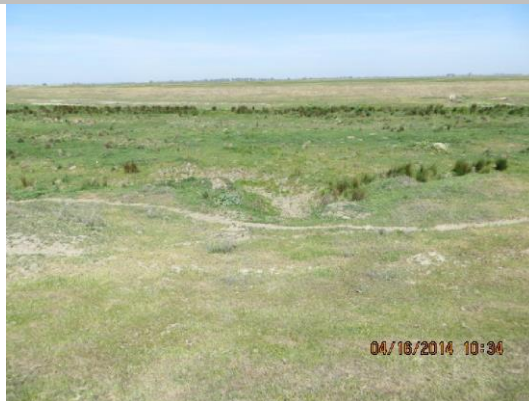
Photo 1 of 3 : UCIP_SP_2017_49969_61112.jpg

FS_ID:49969
DS_ID:19838
EP_NO: N/A
Repair Type: Non-Urgent
Crossing Status: Found
UCIP Comments: 7/20/2016 LS inlet buried under dense vegetation. Dense vegetation limits the inspector's visibility to identify signs of pipe failure (leaks) along the WS and LS slope. Recommend removing vegetation along pipe alignment to conduct proper inspection of structure and appurtenances. (DWR UCIP - omagana)4/16/2014 Pipe blocked by silt on LS toe. Flapgate rusty and does not operate correctly. (DWR UCIP - omagana)
FIELD_STRUCT_DESC: 36-inch corrugated metal drainage pipe through levee, 13.4 feet below crown. Flap gate located on the waterside (WS) end. Concrete headwall located on the landside (LS).
[Additional Reference(s): DWR Levee Log, 2002. USACE San Joaquin O&M Manuals: Unit No. 601, 1967, (HLM 3.06), Unit No. 601 Part I, 1967 (Amended in 1978), Unit No. 601 Part II, 1969, and Unit No. 601 Part III, 1969]

Pipe, headwall, and flapgate on WS toe.

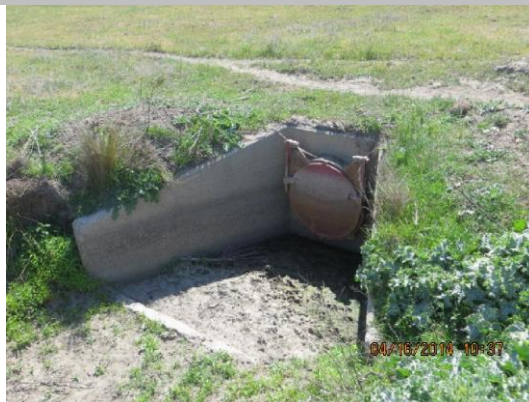
Photo 2 of 3 : UCIP_SP_2017_49969_61113.jpg

Pipe, headwall, and flapgate on WS toe.

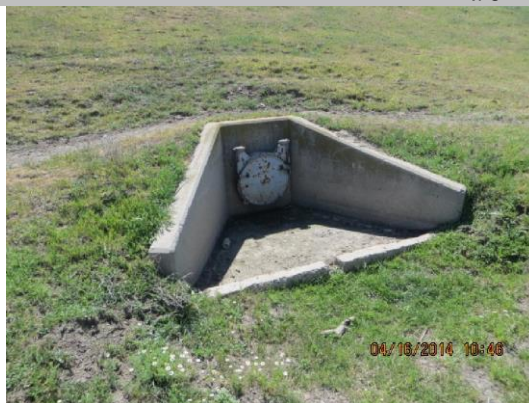
Photo 2 of 3 : UCIP_SP_2017_33764_61127.jpg

Pipe, flapgate, and headwall on WS toe.

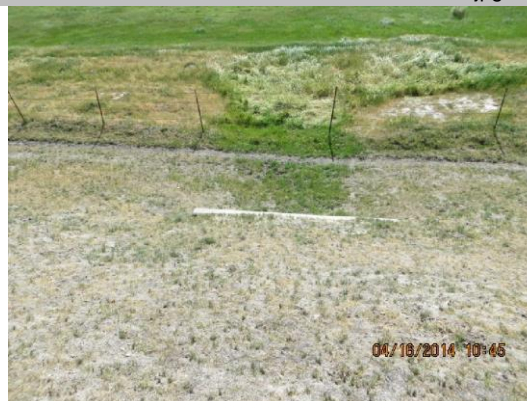
Photo 3 of 3 : UCIP_SP_2017_33764_61129.jpg

Pipe and headwall on LS toe.

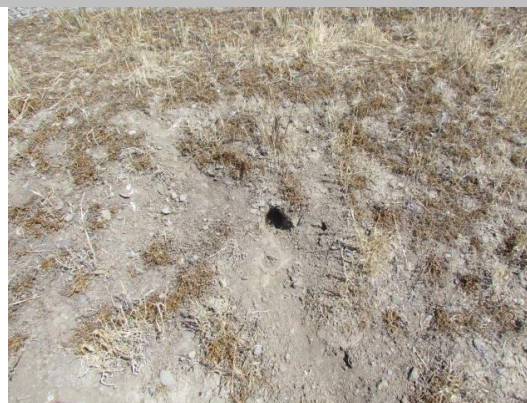
Photo 1 of 1 : SP_2017_NA0010_126_3_20170417_00001.jpg

LM Start	3.40	Rating **	M	Issue No.	3
LM End	3.54	Issue Type +	Ma	Location *	LS
Category	Earthen Levee			GPS Latitude/Longitude	
				Start	End
Item	Animal Control			37.253052 °	37.253600 °
				-120.722647 °	-120.720198 °
DWR ID	DWR_NA0010_08_s_2012_3				
Comment Code					
A3 : No rodents visible, but rodent burrows visible; need to backfill and compact or grout burrows.					
Inspector Comment					
Noted several rodent holes on landward slope within this reach.

Looking at typical view of rodent holes on landward slope.

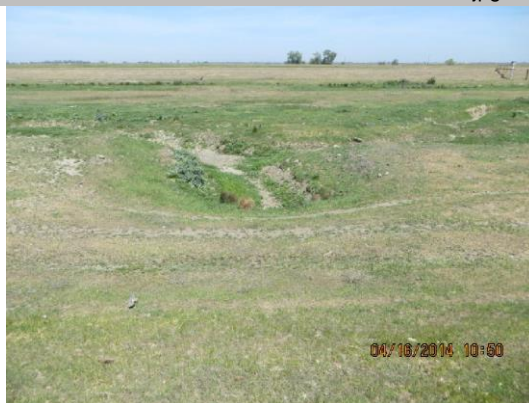
Photo 1 of 3 : UCIP_SP_2017_39513_61134.jpg

LM Start	3.43	Rating **	M	Issue No.	33
LM End	3.43	Issue Type +	Ma	Location *	LS
Category	Supplemental			GPS Latitude/Longitude	
				Start	End
Item	DWR UCIP LMA Responsibility			37.253151 °	37.253151 °
				-120.722182 °	-120.722182 °
DWR ID					
Comment Code					
Inspector Comment					
FS_ID:39513 DS_ID:19840 EP_NO: N/A Repair Type: Non-Urgent Crossing Status: Found UCIP Comments: No access available on landward side. Need to confirm status of crossing. FIELD_STRUCT_DESC: 24-inch CM stormdrain pipe through levee, 13.0 feet below crown. Flap gate on the waterward end. Concrete headwall on both ends. (USACE-1967). This entry matches the Drainage or Irrigation Structure referenced in O&M manual (HLM 3.43). FS Date: 4/16/2014

Pipe, headwall, and flapgate on WS toe.

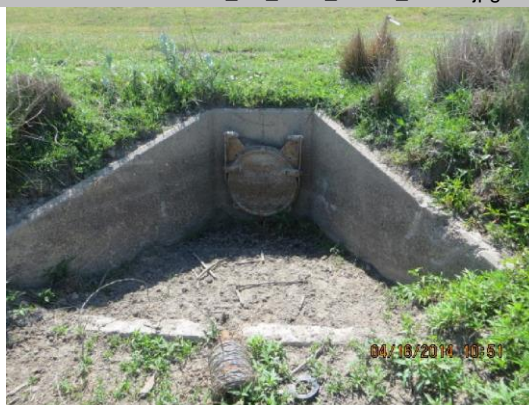
Photo 2 of 3 : UCIP_SP_2017_39513_61133.jpg

Pipe, headwall, and flapgate on WS toe.

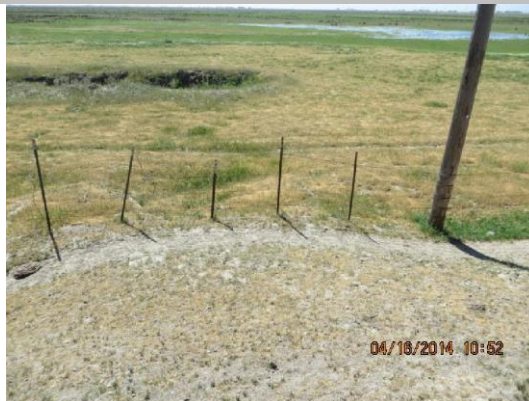
Photo 3 of 3 : UCIP_SP_2017_39513_61132.jpg

Pipe likely at drainage swale off LS toe.

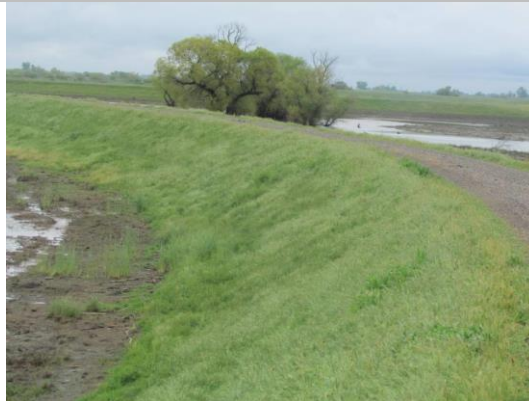
Photo 1 of 1 : SP_2017_NA0010_127_4_20170425_00012.jpg

LM Start	0.00	Rating **	M	Issue No.	4
LM End	0.87	Issue Type +	Ma	Location *	LS
Category	Earthen Levee			GPS Latitude/Longitude	
				Start	End
Item	Vegetation			37.220282 °	37.220058 °
				-120.713077 °	-120.698240 °
DWR ID	DWR_NA0010_09_s_2017_4				
Comment Code					
V1 : Control annual grass and weeds on the levee slopes and easements.					
Inspector Comment

Looking at typical view of landward slope.

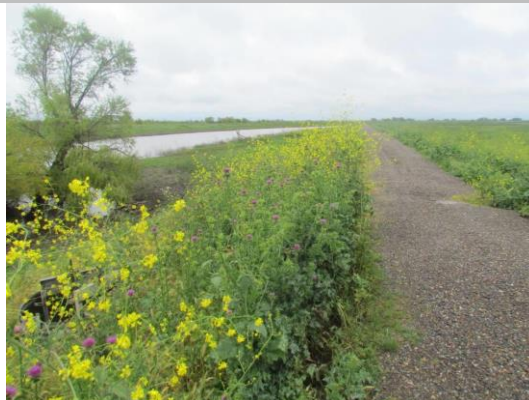
Photo 1 of 1 : SP_2017_NA0010_127_6_20170425_00011.jpg

LM Start	0.00	Rating **	U	Issue No.	6
LM End	0.87	Issue Type +	Ma	Location *	WS
Category	Earthen Levee			GPS Latitude/Longitude	
				Start	End
Item	Vegetation			37.220282 °	37.220058 °
				-120.713077 °	-120.698240 °
DWR ID	DWR_NA0010_09_s_2017_6				
Comment Code					
V1 : Control annual grass and weeds on the levee slopes and easements.					
Inspector Comment

Looking downstream at dense veg on waterward slope.

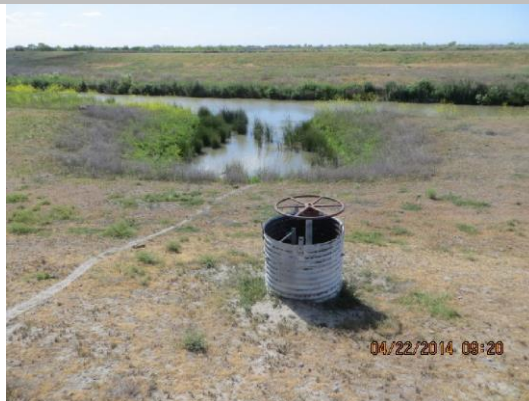
Photo 1 of 3 : UCIP_SP_2017_39888_62119.jpg

FS_ID:39888
DS_ID:19841
EP_NO: N/A
Repair Type: Non-Urgent
Crossing Status: Found
UCIP Comments: Concrete headwalls on landward and waterward under water. Need photo to confirm condition of concrete headwalls, pipe, and gate on both toes.
FIELD_STRUCT_DESC: 24-inch C.M. stormdrain pipe through the levee, 18.7-feet below the crown. Slide gate inside 36-inch C.M. pipe riser on the waterward slope. Concrete "U" headwalls on both ends. (USACE-1967). This entry matches the Drainage or Irrigation Structure referenced in O&M manual (HLM 0.47).
FS Date: 4/22/2014

Slide gate in CMP riser on WS slope with outlet visible in background.

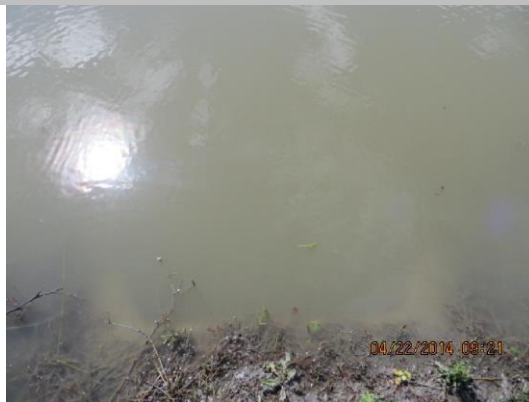
Photo 2 of 3 : UCIP_SP_2017_39888_62117.jpg

Concrete headwall visible under water on WS toe.

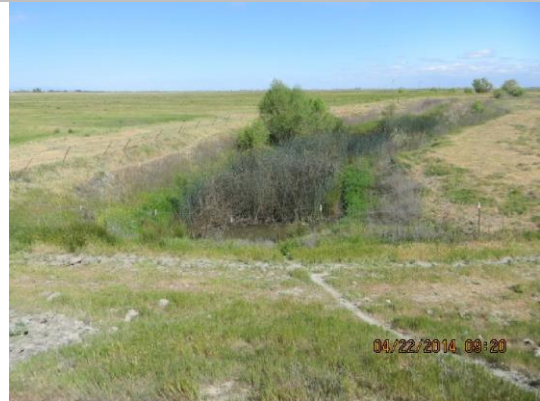
Photo 3 of 3 : UCIP_SP_2017_39888_62118.jpg

Comment Code						
Inspector Comment						
FS_ID:39888						
DS_ID:19841						
EP_NO: N/A						
Repair Type: Non-Urgent						
Crossing Status: Found						
UCIP Comments: Concrete headwalls on landward and waterward under water. Need photo to confirm condition of concrete headwalls, pipe, and gate on both toes.						
FIELD_STRUCT_DESC: 24-inch C.M. stormdrain pipe through the levee, 18.7-feet below the crown. Slide gate inside 36-inch C.M. pipe riser on the waterward slope. Concrete "U" headwalls on both ends. (USACE-1967). This entry matches the Drainage or Irrigation Structure referenced in O&M manual (HLM 0.47).						
FS Date: 4/22/2014

Concrete headwall visible at inlet on LS toe.

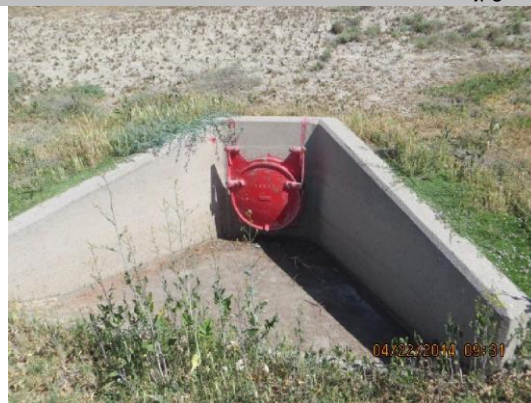
Photo 2 of 3 : UCIP_SP_2017_39515_62132.jpg

FS_ID:39515
DS_ID:19842
EP_NO: N/A
Repair Type: Non-Urgent
Crossing Status: Found
UCIP Comments: Animal burrows in area on LS slope. Minor sediment buildup in pipe visible on landward side--recommend clearing.
FIELD_STRUCT_DESC: 24-inch C.M. stormdrain pipe through the levee, 8.7-feet below the crown. Flap gate on the waterward end. Concrete headwall on the landward end. Concrete "U" headwall on the waterward end. (USACE-1967). This entry matches the Drainage or Irrigation Structure referenced in O&M manual (HLM 0.70).
FS Date: 4/22/2014

Headwall, flapgate, and pipe on WS toe.

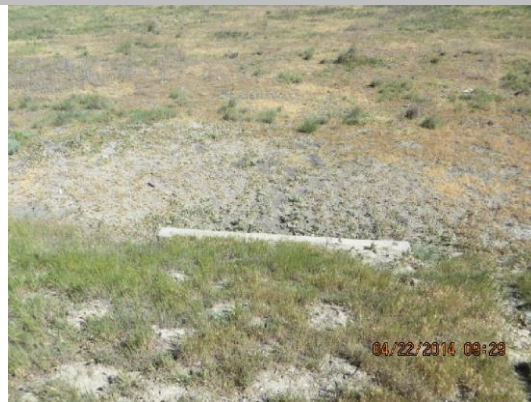
Photo 3 of 3 : UCIP_SP_2017_39515_62129.jpg

Headwall and pipe on LS toe.

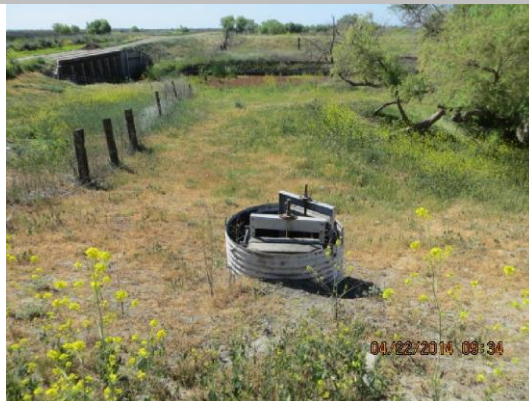
Photo 1 of 3 : UCIP_SP_2017_34186_62134.jpg

48-inch CMP riser with slide gates on WS slope.
